708P91370
April 2017

Xerox® VersaLink® B7025/B7030/B7035 Multifunction Printer Service Manual

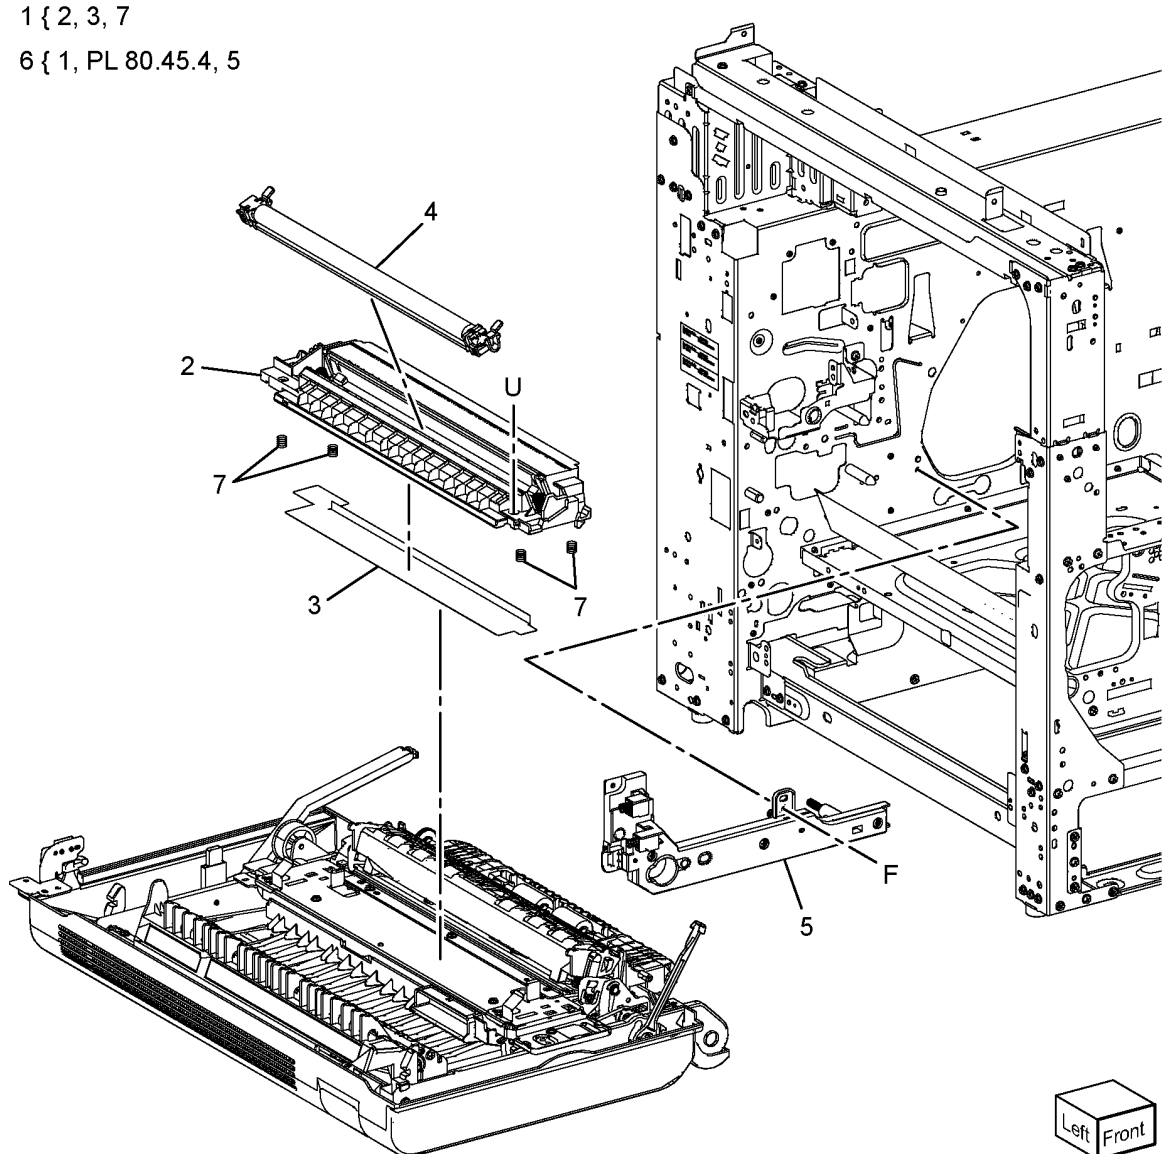
Y-8-0003-A

PL 90.15 BTR Roll

Item	Part	Description
1	-	Transfer chute assembly (Not Spared)
2	-	Transfer chute (P/O PL 90.15 Item 1)
3	-	Mylar strip (P/O PL 90.15 Item 1)
4	115R00116	BTR assembly (see NOTE) (REP 90.3)
5	848K94950	Conductor housing assembly
6	604K96900	Transfer chute kit
7	-	Chute spring (P/O PL 90.15 Item 1)

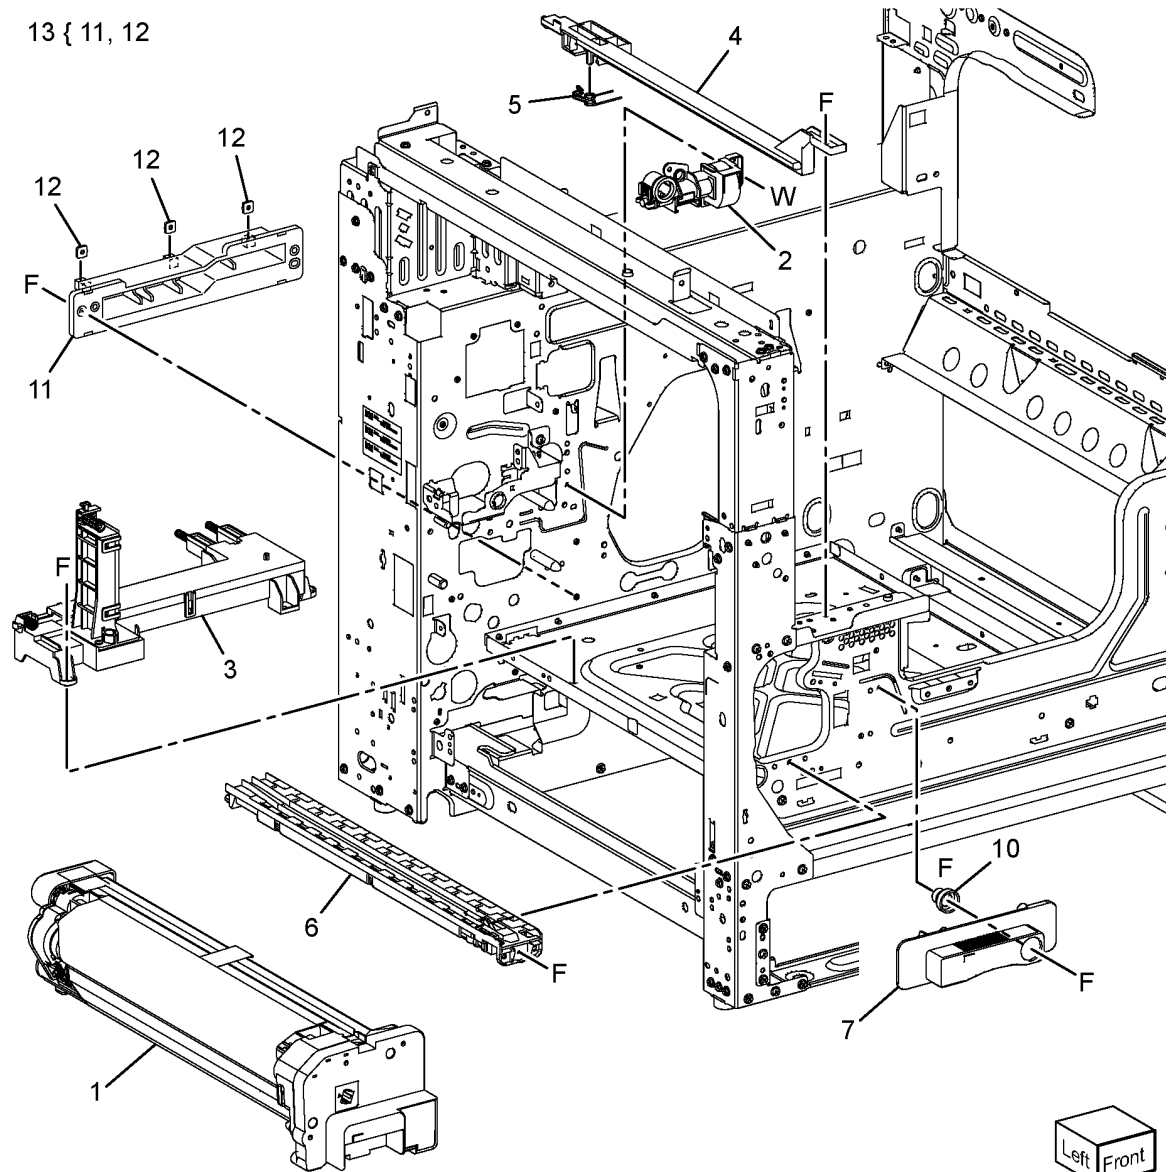
Y-8-0005-A

PL 90.20 Xerographic Components

Item	Part	Description
1	113R00779	Drum cartridge (REP 90.4)
2	052K13870	Reclaim pipe assembly (REP 90.5)
3	848K94940	AC housing assembly (REP 90.6)
4	-	CRU upper guide (Not Spared)
5	-	Conductor (Not Spared)
6	-	Lower guide assembly (Not Spared)
7	803E27170	CRU handle
8	-	Not used
9	-	Not used
10	013E38891	Handle bearing
11	-	HV conductor housing (P/O PL 90.20 Item 13)
12	-	Plate nut (P/O PL 90.20 Item 13)
13	604K96920	HV housing assembly

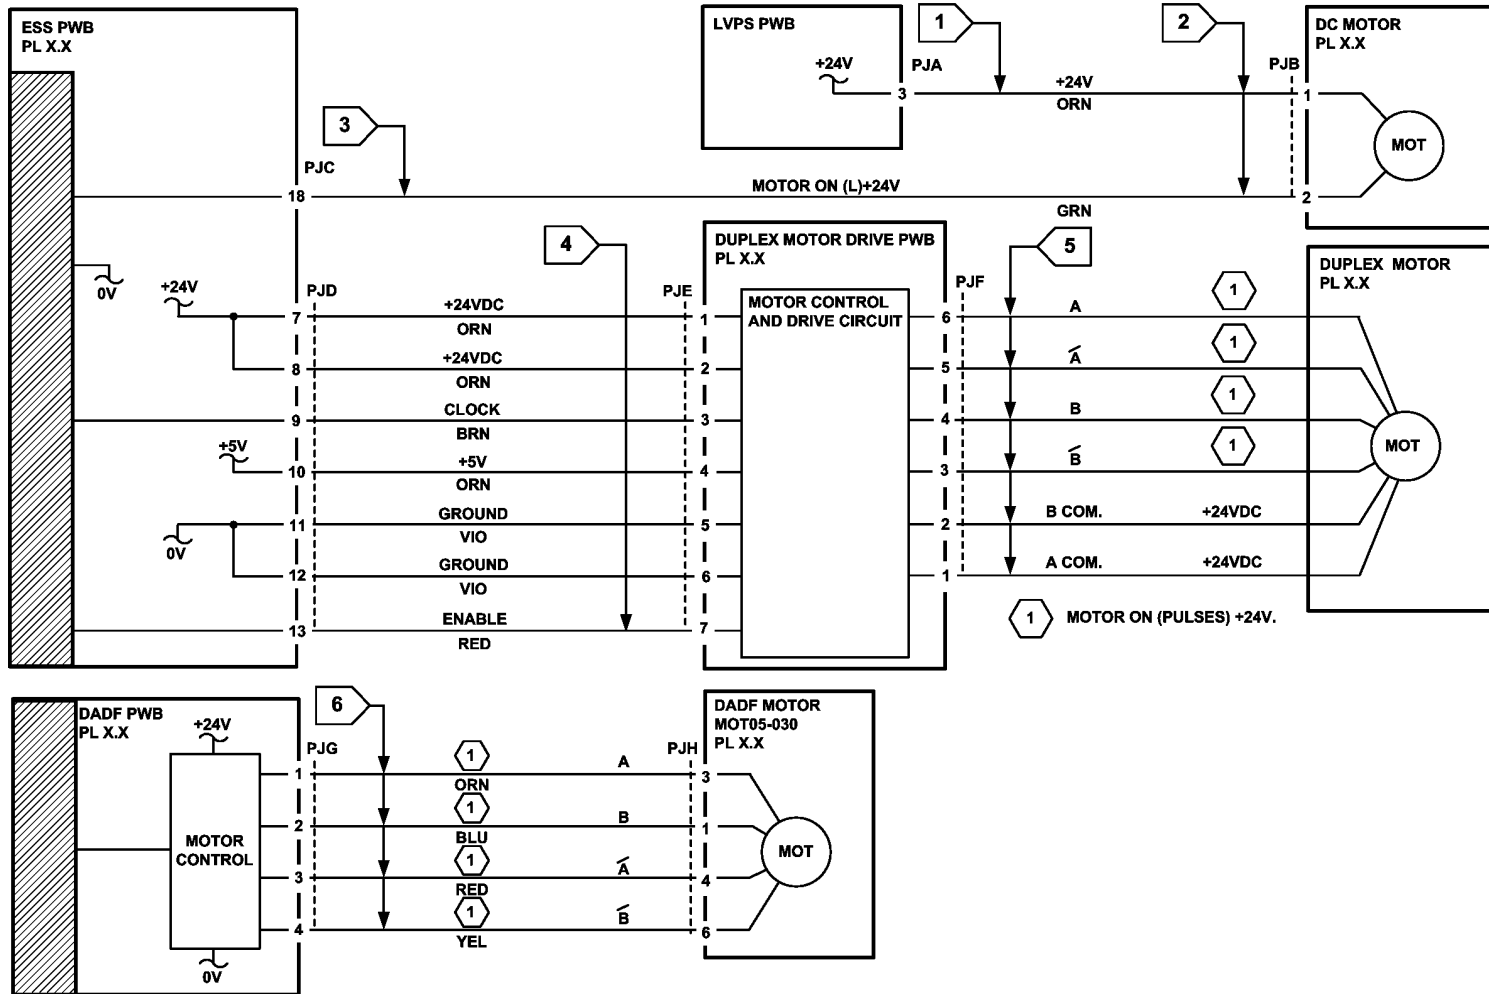
TY-1-0159-A

- Disconnect PJF (Flag 5). Check the +24V supply and the motor on pulses when the component control code for the motor is entered.
- Disconnect PJD (Flag 4). Check the +24V, +5V and 0V supplies.
- Check the clock pulses (Flag 4).
- Check that the signal on PJD pin 13 (Flag 4) changes when the component control code for the motor is entered.
- Check the wiring and the connectors for the motor circuit.

Figure 1 Wiring diagram

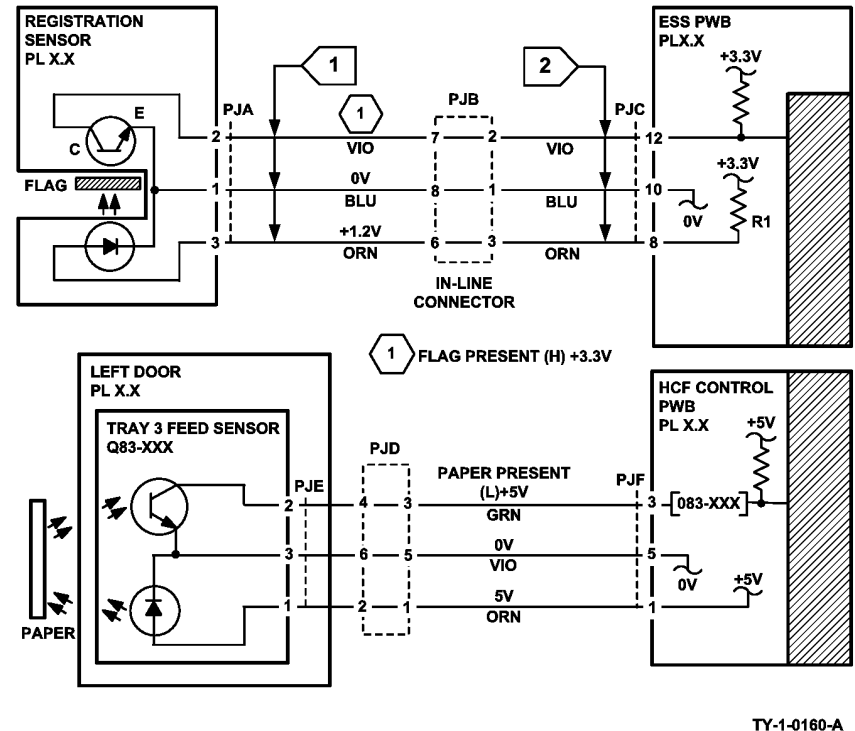
TY-1-0160-A

- Disconnect PJA ([Flag 1](#)). Check for +3.3V and 0V at PJA on the harness.
- Disconnect PJC ([Flag 2](#)). Check the wiring and the connectors for the sensor circuit.
- Check for +3.3V and 0V at PJC ([Flag 2](#)) on the ESS PWB.
- If necessary, install new components or repair the wiring.

Figure 1 Wiring diagram

For the upper sensor in [Figure 1](#):

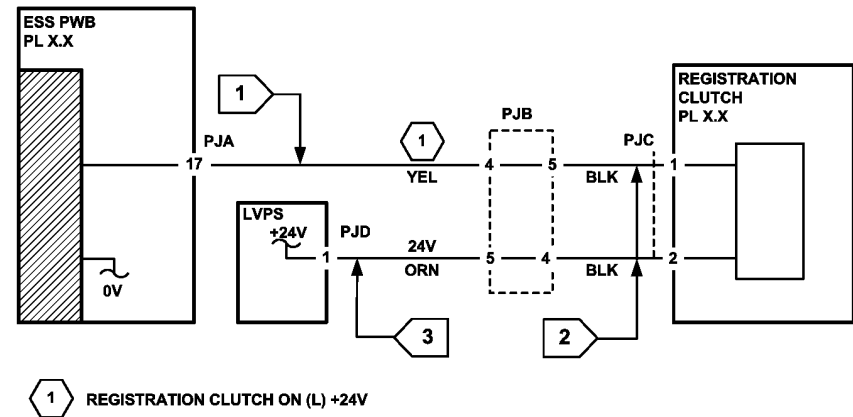
TY-1-0161-A

- Check that the signal changes on the ESS PWB (Flag 1) when the component control code for the clutch or solenoid is entered.
- Disconnect PJC (Flag 2). Check that +24V is measured when the component control code for the clutch or solenoid is entered.
- Disconnect PJD (Flag 3). Check for +24V on the LVPS.
- Check the wiring and the connectors for the clutch or solenoid circuit.

Figure 1 Wiring diagram

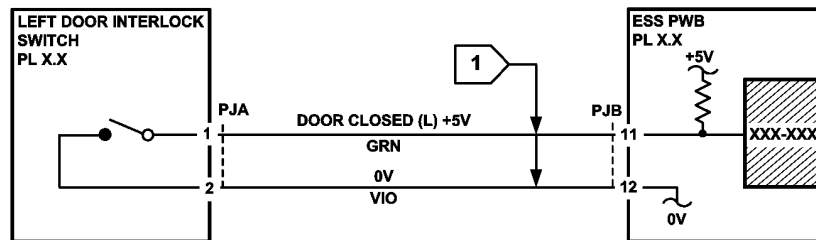
TY-1-0162-A

- Disconnect PJA (Flag 1). Check the electrical operation of the switch.
- Disconnect PJB (Flag 1). Check for +5V and 0V on the IOT PWB.
- Check the wiring and the connectors for the switch circuit.

Figure 1 Wiring diagram

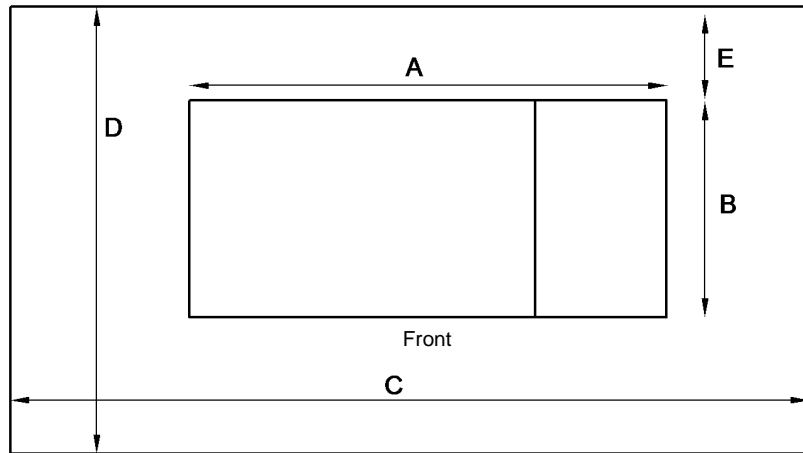
Y-1-0441-A

Configuration	Machine Width (bypass tray closed) (A) mm/inches	Machine Depth (B) mm/inches	Install Width Required (C) mm/inches		Install Depth Required (D) mm/inches		Install Airflow/Service Work Space (E) mm/inches	
			Moveable	Fixed	Moveable	Fixed	Moveable	Fixed
Single tray machine	968 / 38.1	670 / 26.3	1968 / 77.5	2968 / 117	1670 / 65.7	2670 / 105.1	100 / 4	1000 / 39.4
Stacked machine (1TM, TTM or 3TM) with HCF	984 / 38.7	670 / 26.3	1984 / 78.1	2984 / 117.4	1670 / 65.7	2670 / 105.1	100 / 4	1000 / 39.4
Stacked machine (1TM, TTM or 3TM) with integrated office finisher	1035 / 40.7	670 / 26.3	2035 / 80.1	3035 / 119.5	1670 / 65.7	2670 / 105.1	100 / 4	1000 / 39.4
Stacked machine (1TM, TTM or 3TM) with office finisher	1572 / 61.9	670 / 26.3	2572 / 101.2	3572 / 140.6	1670 / 65.7	2670 / 105.1	100 / 4	1000 / 39.4
Stacked machine (1TM, TTM or 3TM) with office finisher and HCF	1588 / 62.5	670 / 26.3	2588 / 101.8	3588 / 141.2	1670 / 65.7	2670 / 105.1	100 / 4	1000 / 39.4

Stacked machine (1TM, TTM or 3TM) with office finisher and booklet maker	1572 / 61.9	681 / 26.8	2572 / 101.2	3572 / 140.6	1681 / 66.1	2681 / 105.5	100 / 4	1000 / 39.4
Stacked machine (1TM, TTM or 3TM) with office finisher, booklet maker and HCF	1588 / 62.5	681 / 26.8	2588 / 101.8	3588 / 141.2	1681 / 66.1	2681 / 105.5	100 / 4	1000 / 39.4

Figure 1 Installation plan

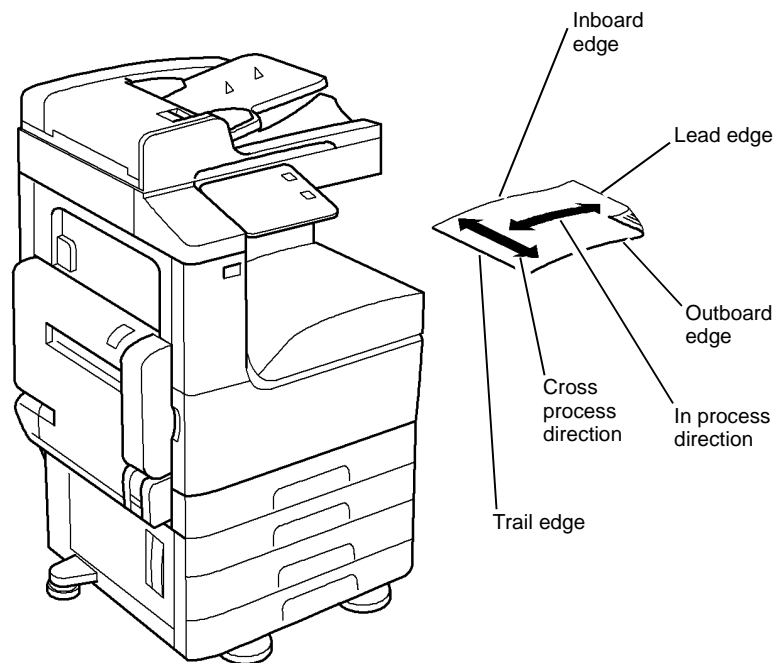
Y-1-0431-A

- **Inboard edge** - can also be described as the top edge or side edge.
- **In process direction** - can also be described as the slow scan direction.
- **Cross process direction** - can also be described as the fast scan direction.

Figure 1 Print/copy orientation definitions

Refer to [Figure 1](#). Be aware of the points that follow:

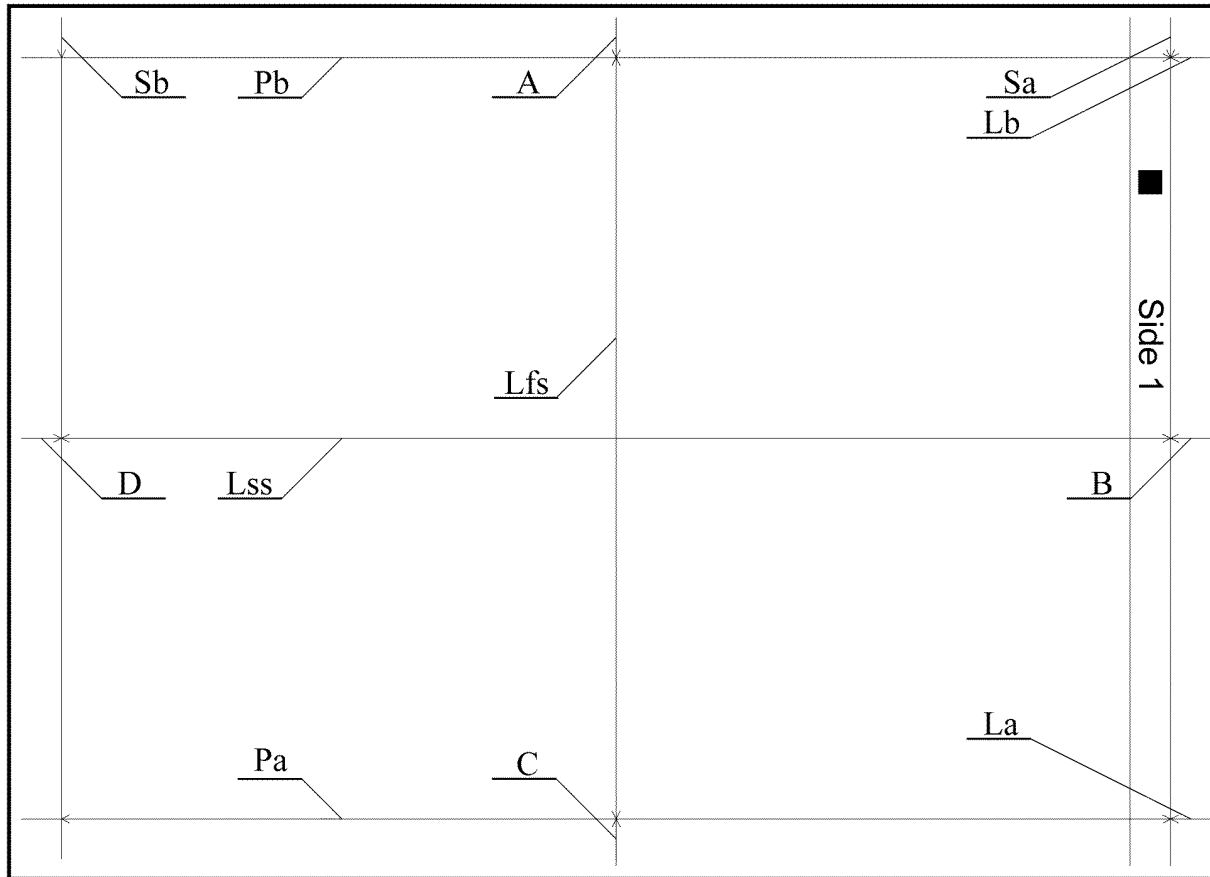
Figure 1 Registration test pattern side 1

1. Enter Diagnostics, [GP 1](#).
2. Touch dC126 System Registration.
3. Touch Paper Supply. Select the tray to adjust.
4. Touch Print. The test pattern will be printed, [Figure 1](#) and [Figure 2](#).

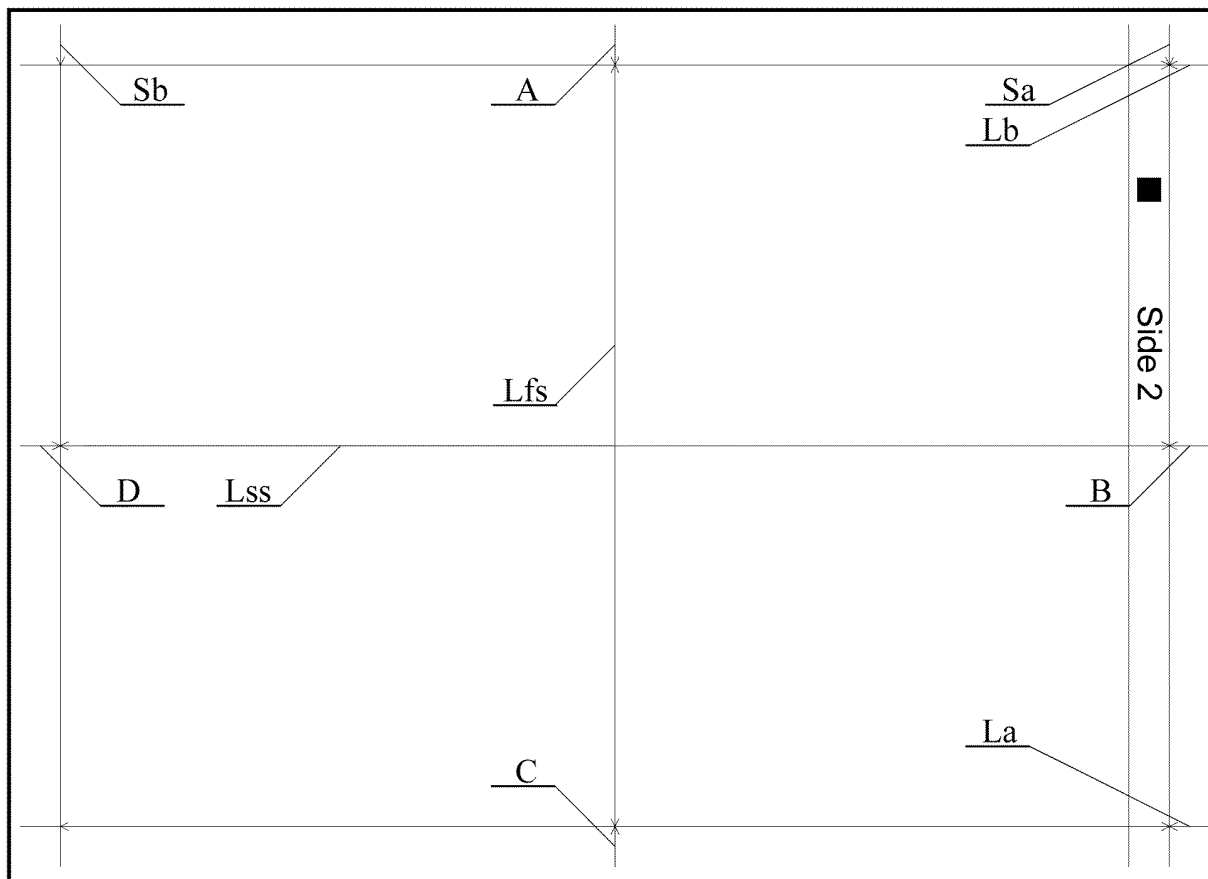
Y-1-0559-A

Figure 2 Registration test pattern side 2

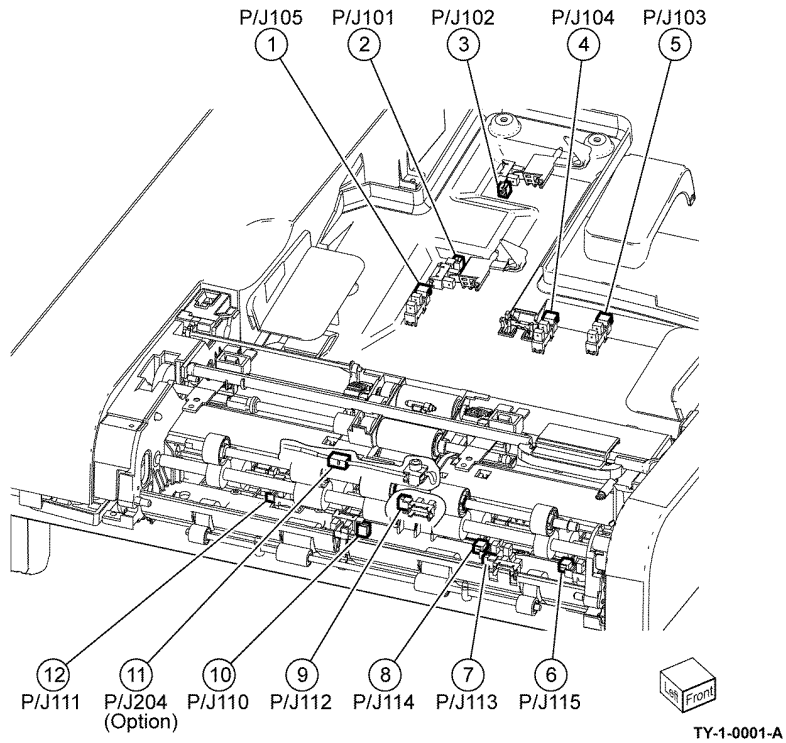
Location: PL 5.05

Figure 1 DADF 1 of 2

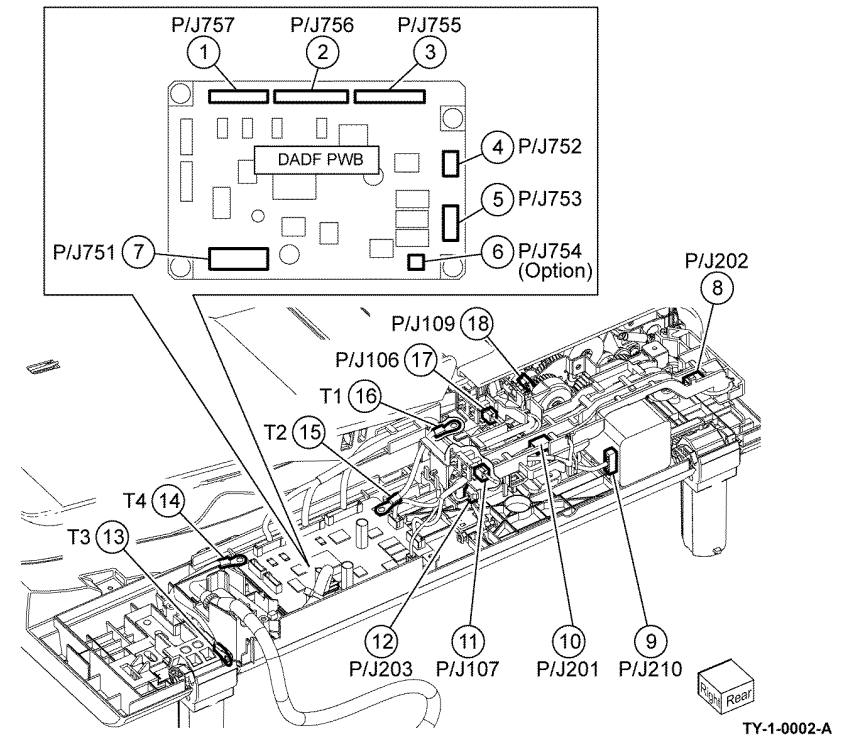
Location: PL 5.05

Figure 2 DADF 2 of 2

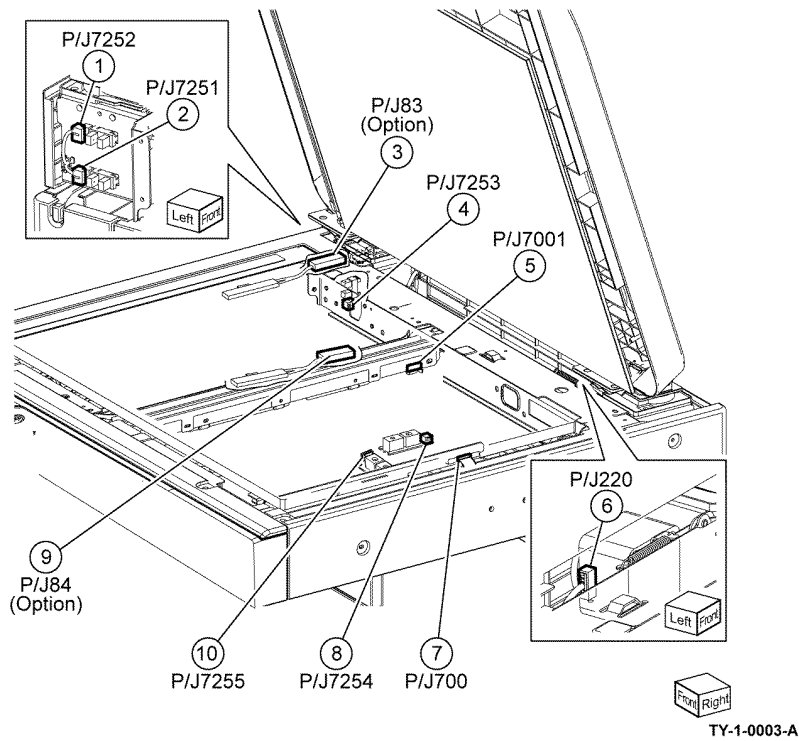
Location: PL 60.05

Figure 3 Scanner assembly

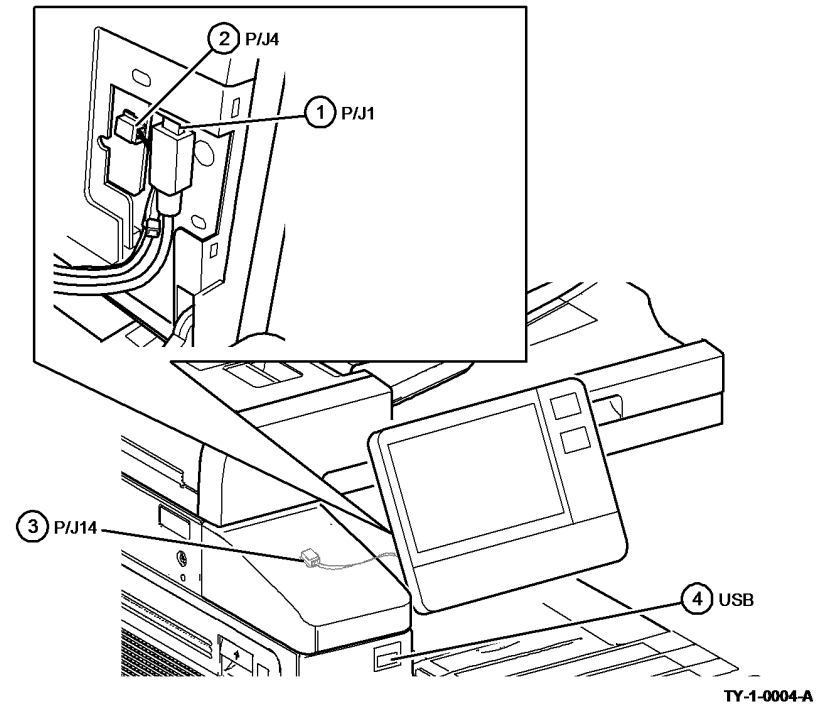
Location: PL 2.05

Figure 4 UI assembly

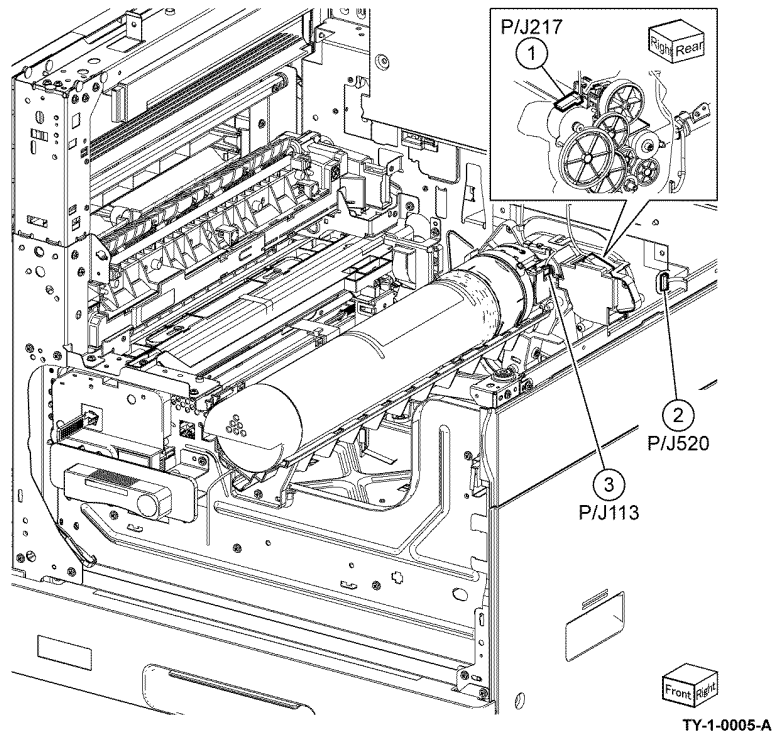
Location: PL 90.10

Figure 5 Toner cartridge CRUM

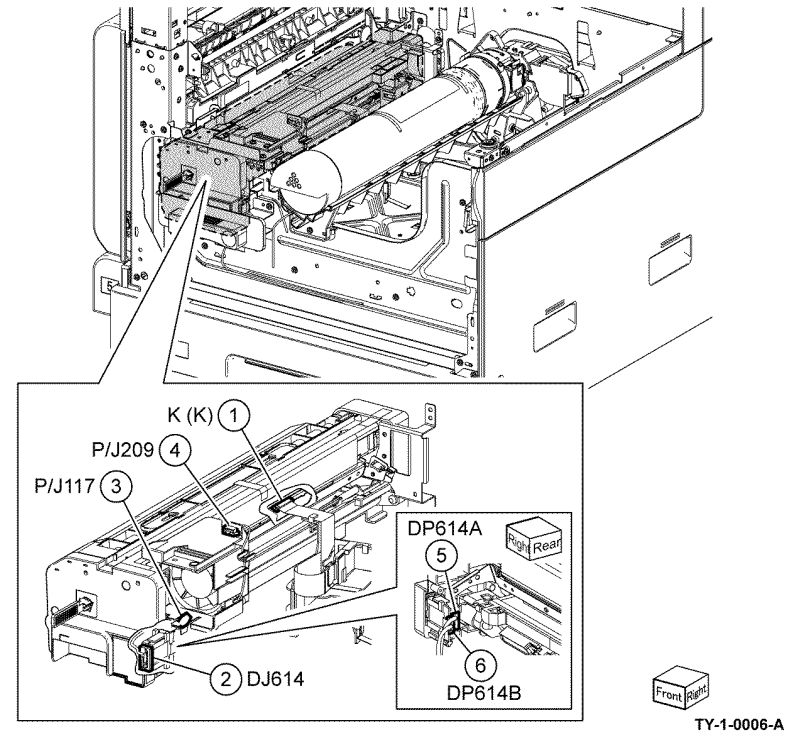
Location: PL 90.20

Figure 6 Drum cartridge

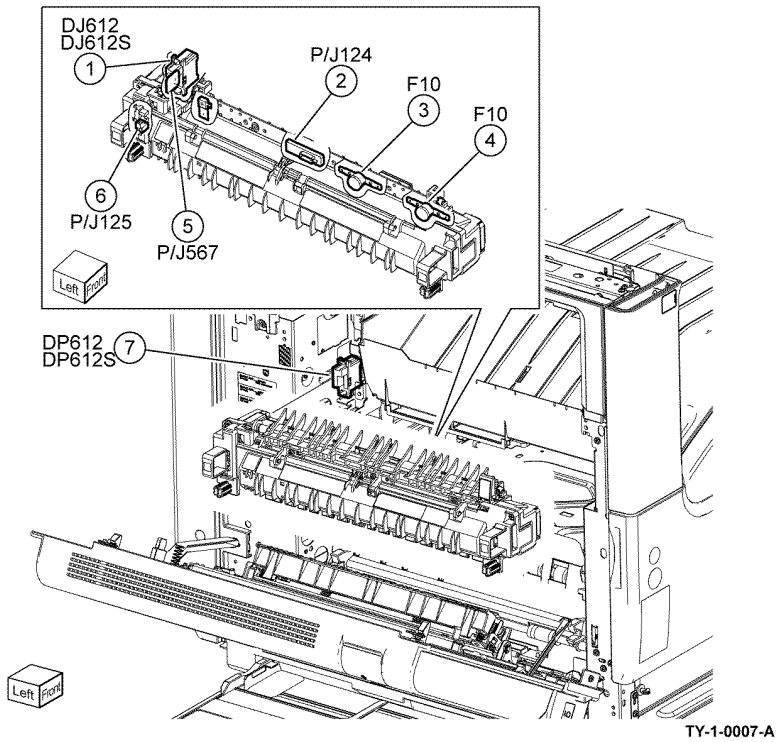
Location: PL 10.05

Figure 7 Fuser

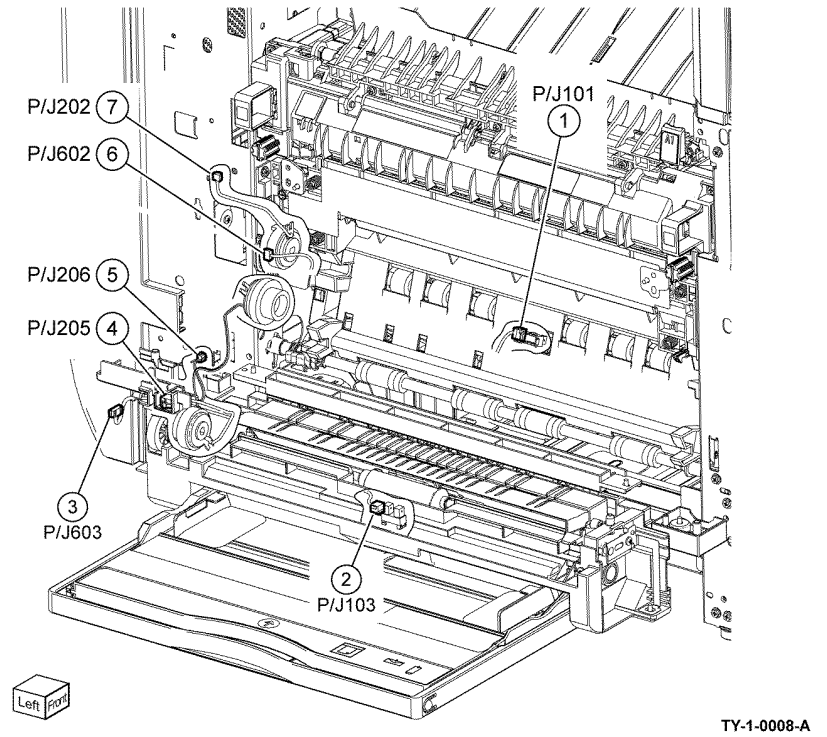
Location: PL 70.30, PL 80.55

Figure 8 Registration and bypass tray

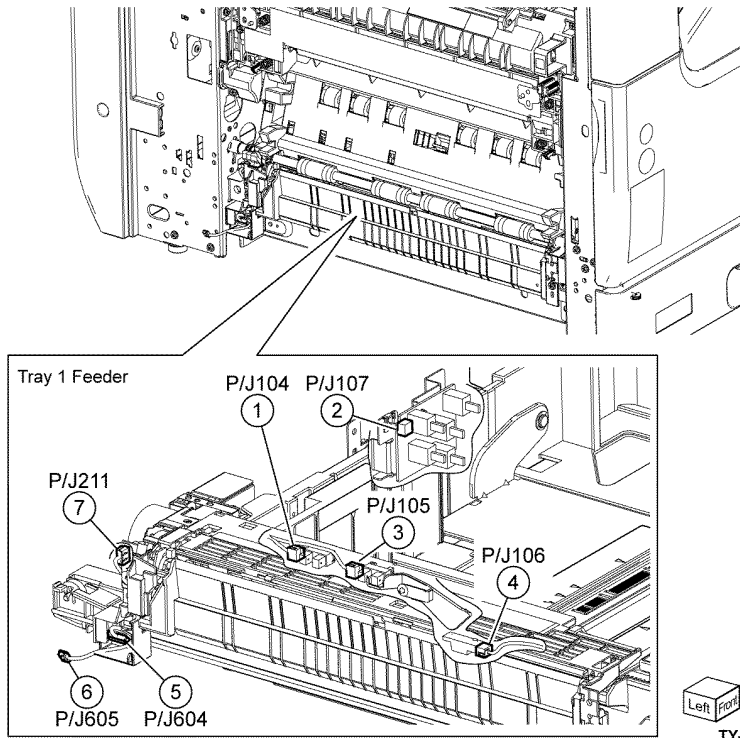
Location: PL 80.05

Figure 9 Tray 1 feeder

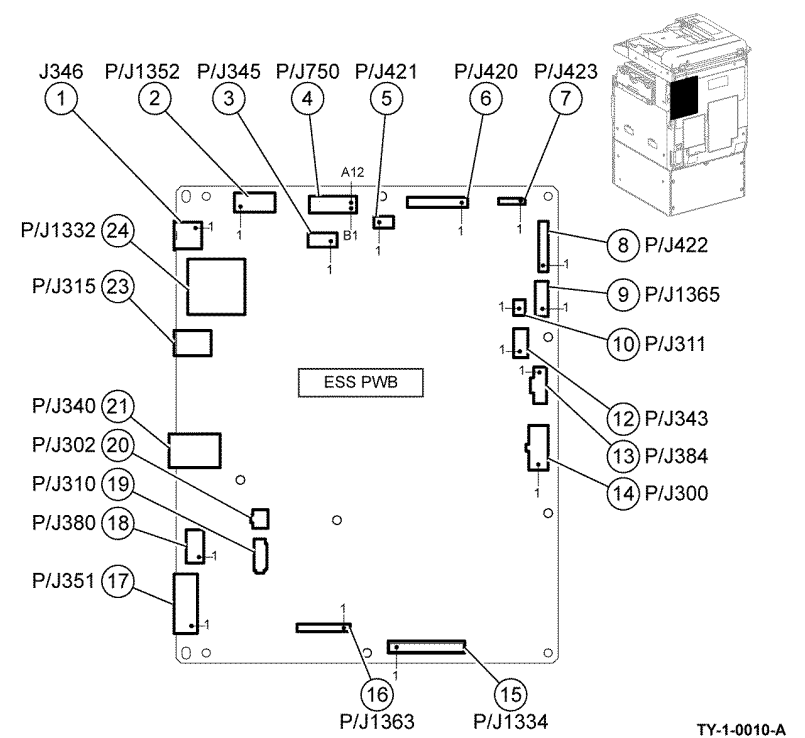
Location: PL 3.10

Figure 10 ESS PWB

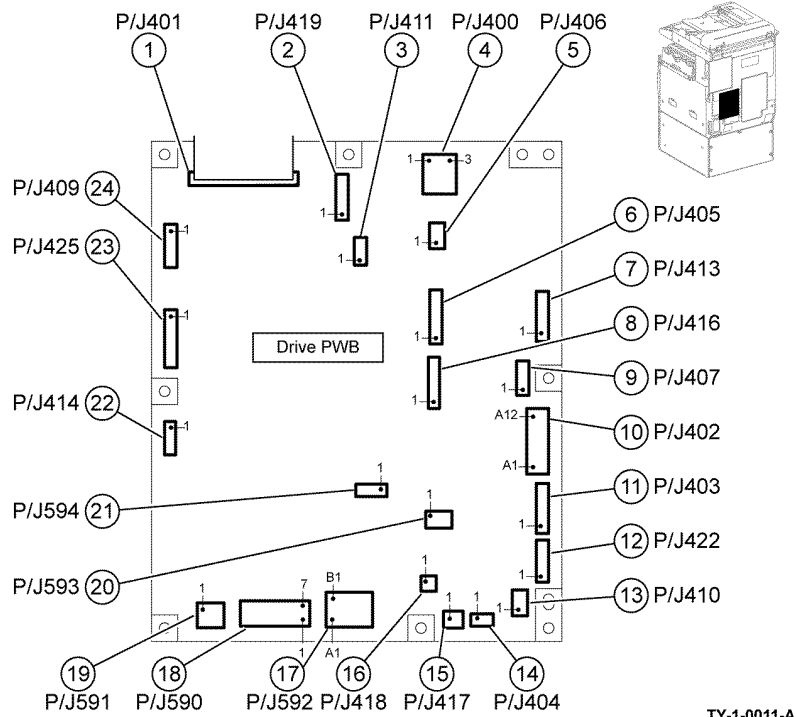
TY-1-0011-A

Figure 11 Drive PWB

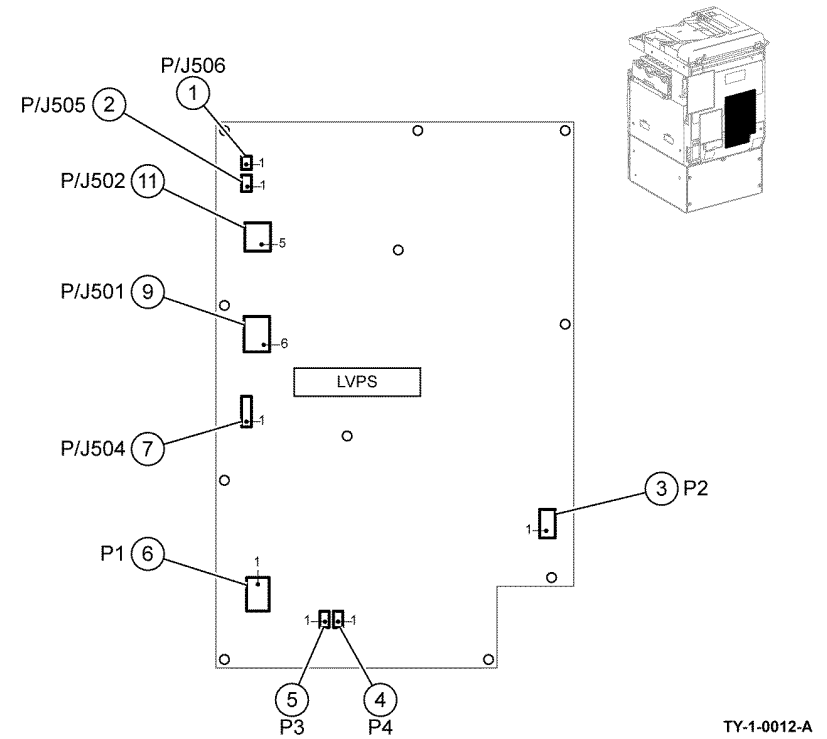
TY-1-0012-A

Figure 12 LVPS

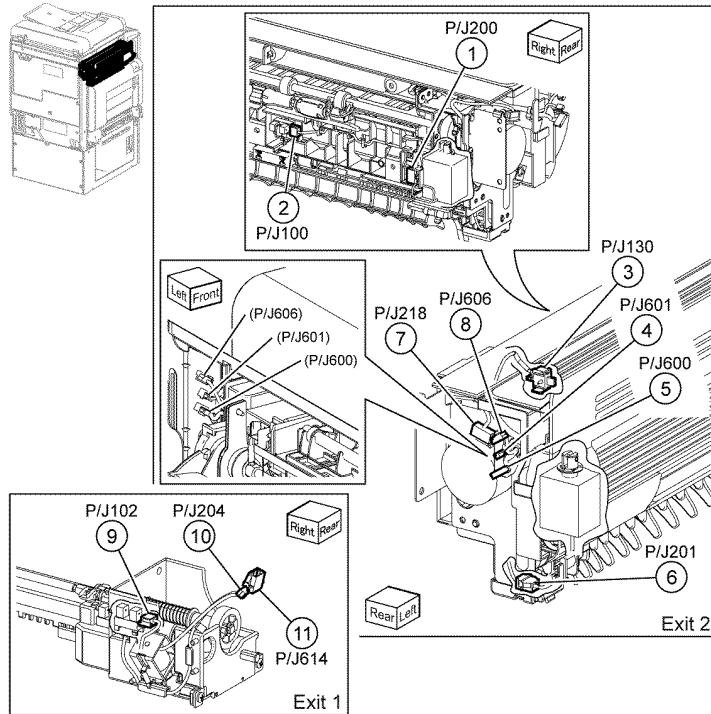
TY-1-0013-A

Figure 13 Exit

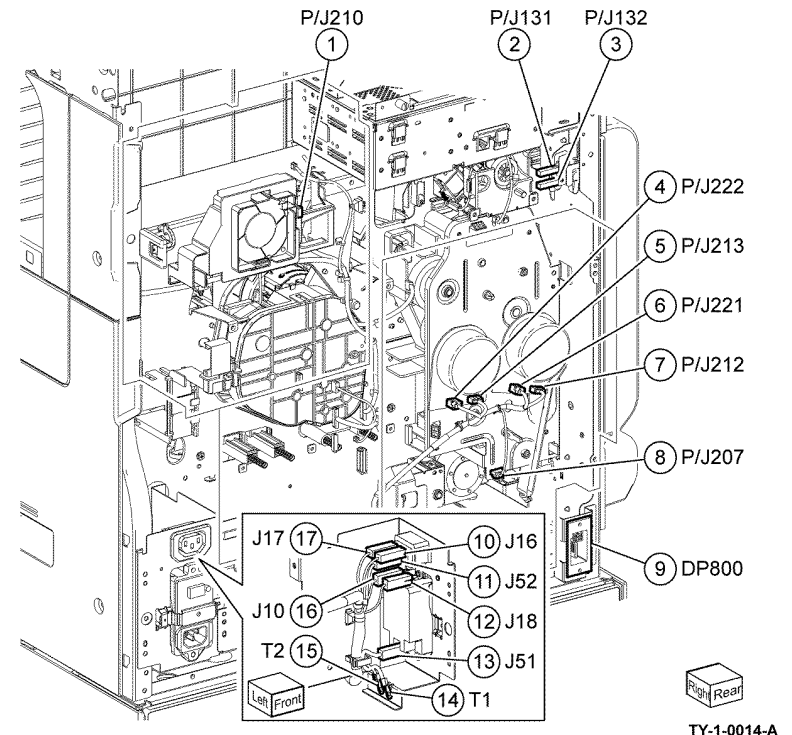
TY-1-0014-A

Figure 14 Machine rear

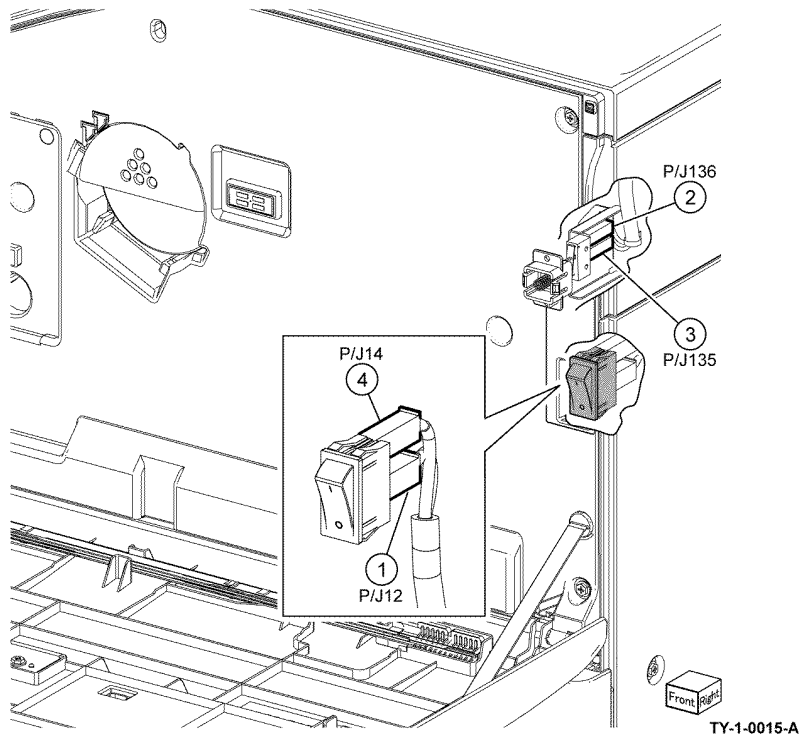
Location: [PL 1.05](#)

Figure 15 Front cover interlock switch

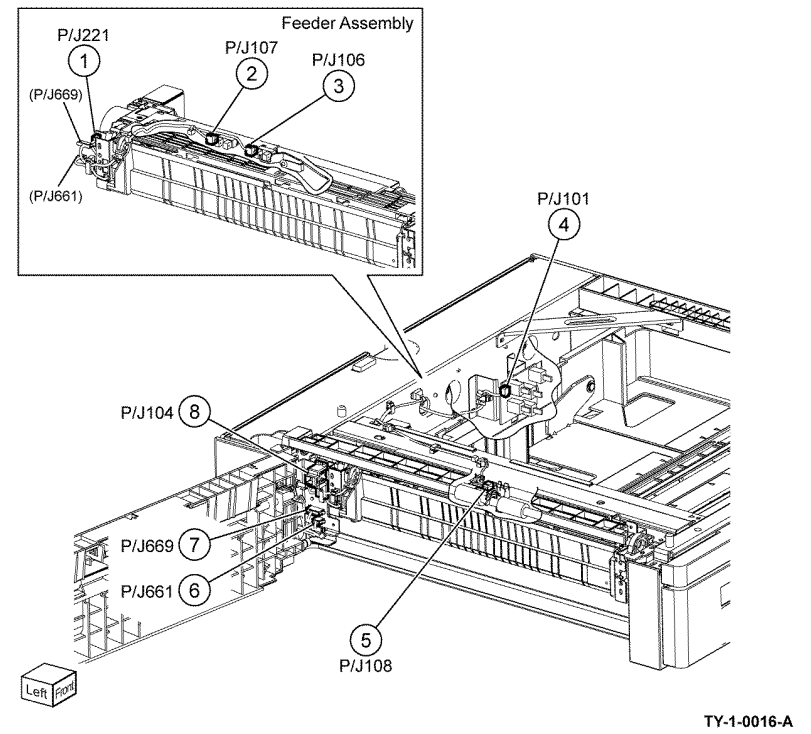
Location: [PL 70.25](#)

Figure 16 Tray module (STM) (1 of 2)

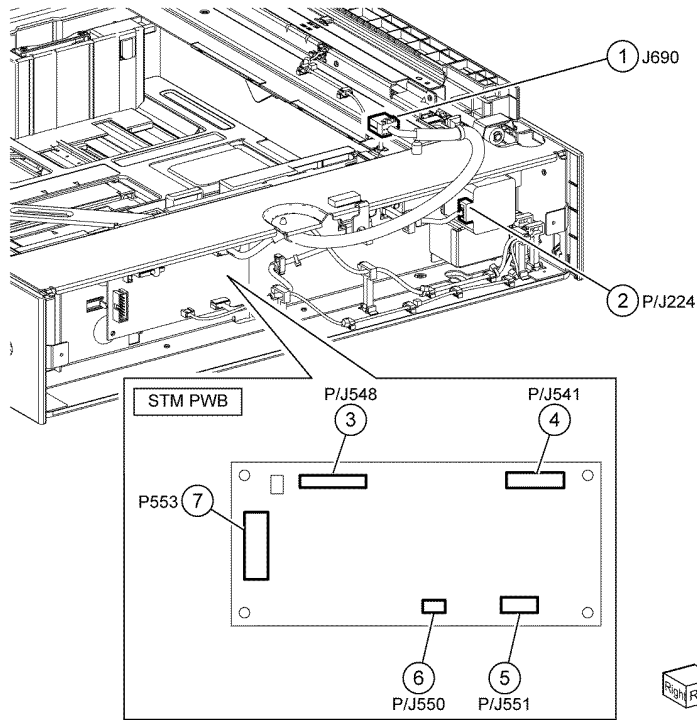
Figure 17 Tray module (STM) (2 of 2)

Tray Module (STM) (2 of 2)

Location: [PL 70.25](#)

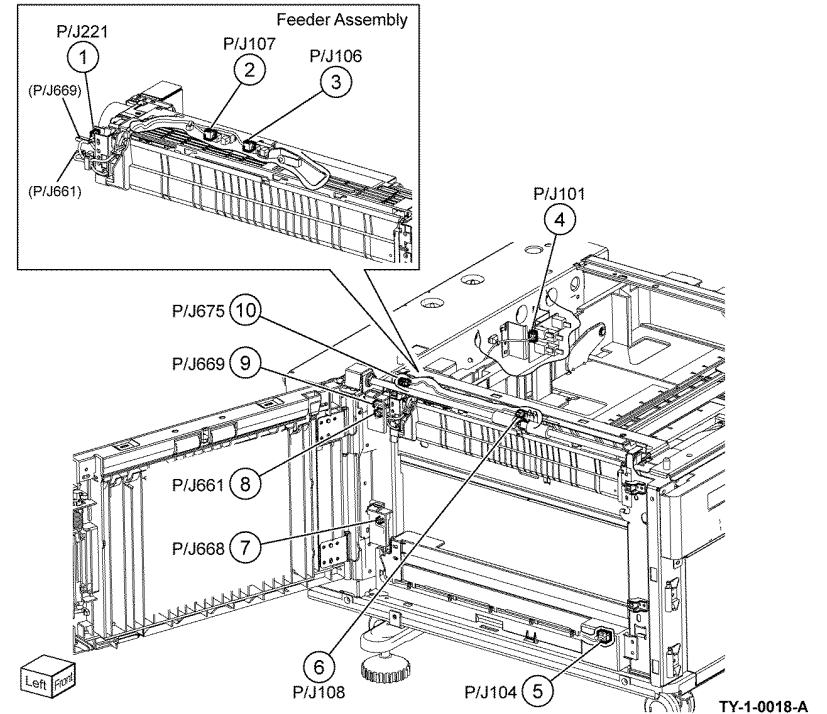
Figure 18 Tray module (1TM) (1 of 2)

Tray Module (1TM) (1 of 2)

Location: [PL 70.15](#)

P/J671	Figure 20	13	Connector (9 pin) (3TM)
P/J671	Figure 23	8	Connector (9 pin) (TTM)
P/J673	Figure 20	11	Connector (9 pin) (3TM)
P/J673	Figure 22	1	Connector (9 pin) (TTM)
P/J674	Figure 22	9	Connector (3 pin) (TTM)
P/J675	Figure 18	10	Connector (3 pin) (1TM)
P/J675	Figure 20	16	Connector (3 pin) (3TM)
P/J675	Figure 23	5	Connector (3 pin) (TTM)
J678	Figure 35	10	HCF
J690	Figure 17	1	Connector (STM)
P/J700	Figure 3	7	CCD assembly
P/J750	Figure 10	4	ESS PWB
P/J751	Figure 2	7	DADF PWB
P/J752	Figure 2	4	DADF PWB
P/J753	Figure 2	5	DADF PWB
P/J754	Figure 2	6	DADF PWB (option)
P/J755	Figure 2	3	DADF PWB
P/J756	Figure 2	2	DADF PWB

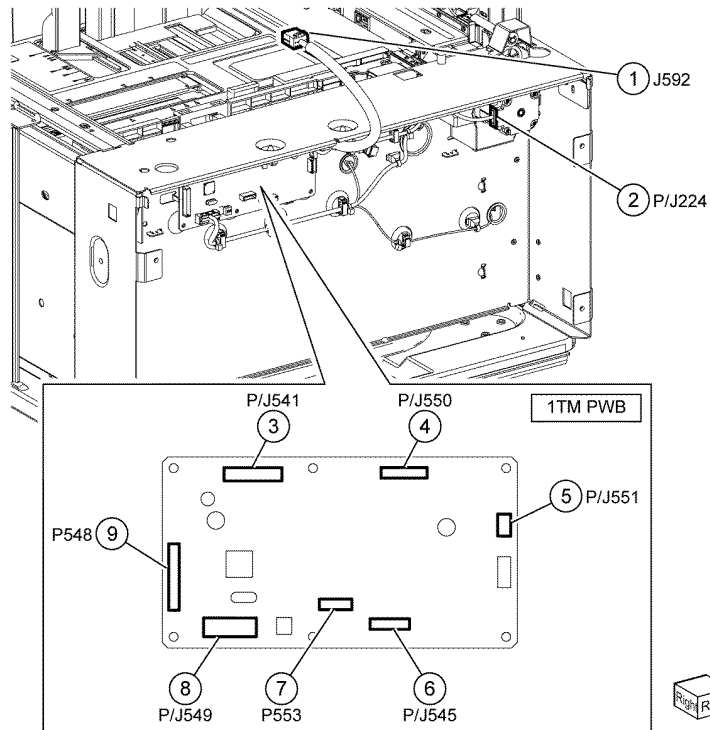
Figure 19 Tray Module (1TM) (2 of 2)

Tray Module (1TM) (2 of 2)

Location: PL 70.15

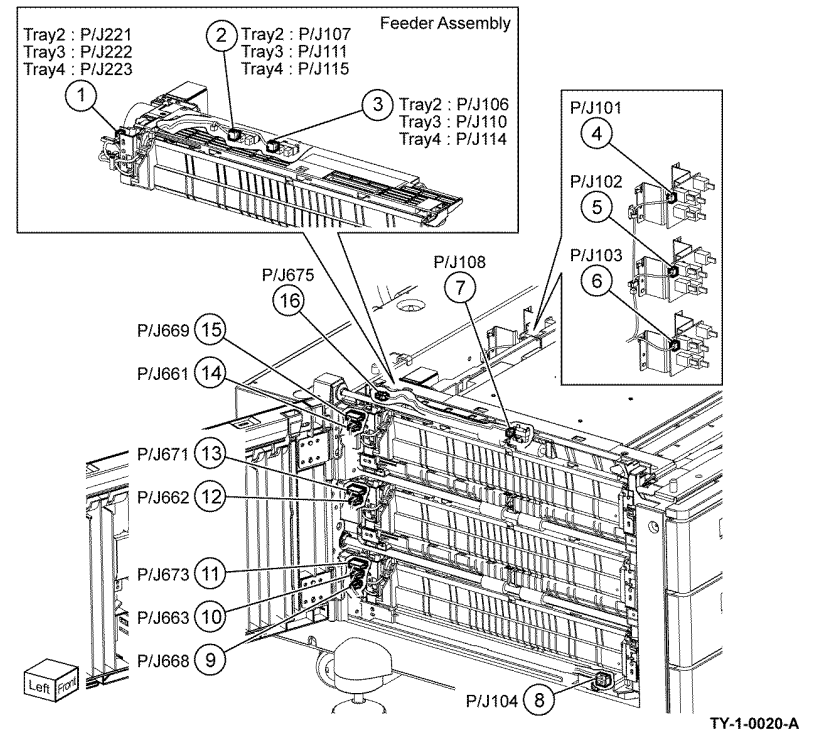
Figure 20 Tray Module (3TM) (1 of 2)

Tray Module (3TM) (1 of 2)

Location: PL 70.20

P/J No	Figure No.	Item No.	PJ Location
P/J604	Figure 9	5	Connector (9 pin)
P/J605	Figure 9	6	Connector (4 pin)
P/J606	Figure 13	8	Connector (4 pin)
DP612	Figure 7	1	Fuser
DJ614	Figure 6	2	Drum cartridge
DP614A	Figure 6	5	Connector
DP614B	Figure 6	6	Connector
P/J614	Figure 13	11	Connector (3 pin)
P/J661	Figure 16	6	Connector (4 pin) (STM)
P/J661	Figure 18	8	Connector (4 pin) (1TM)
P/J661	Figure 20	14	Connector (4 pin) (3TM)
P/J661	Figure 23	6	Connector (4 pin) (TTM)
P/J662	Figure 20	12	Connector (4 pin) (3TM)
P/J662	Figure 23	9	Connector (4 pin) (TTM)
P/J663	Figure 20	10	Connector (4 pin) (3TM)
P/J663	Figure 22	8	Connector (4 pin) (TTM)
P/J668	Figure 18	7	Connector (2 pin) (1TM)
P/J668	Figure 20	9	Connector (2 pin) (3TM)
P/J668	Figure 23	10	Connector (2 pin) (TTM)
P/J669	Figure 16	7	Connector (9 pin) (STM)
P/J669	Figure 18	9	Connector (9 pin) (1TM)
P/J669	Figure 20	15	Connector (9 pin) (3TM)
P/J669	Figure 23	6	Connector (9 pin) (TTM)

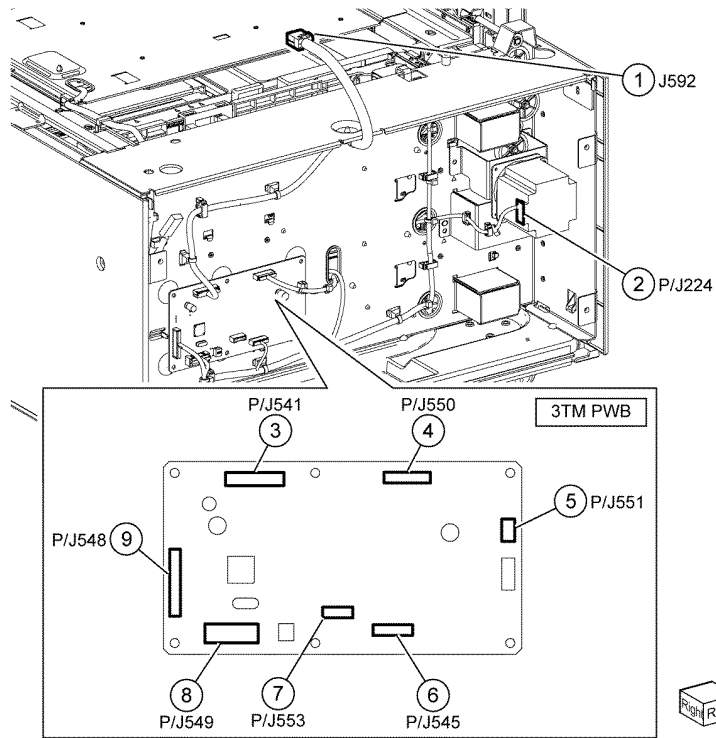
Figure 21 Tray module (3TM) (2 of 2)

Tray Module (3TM) (2 of 2)

Location: PL 70.20
