708P91370
April 2017

Xerox® VersaLink® B7025/B7030/B7035 Multifunction Printer Service Manual

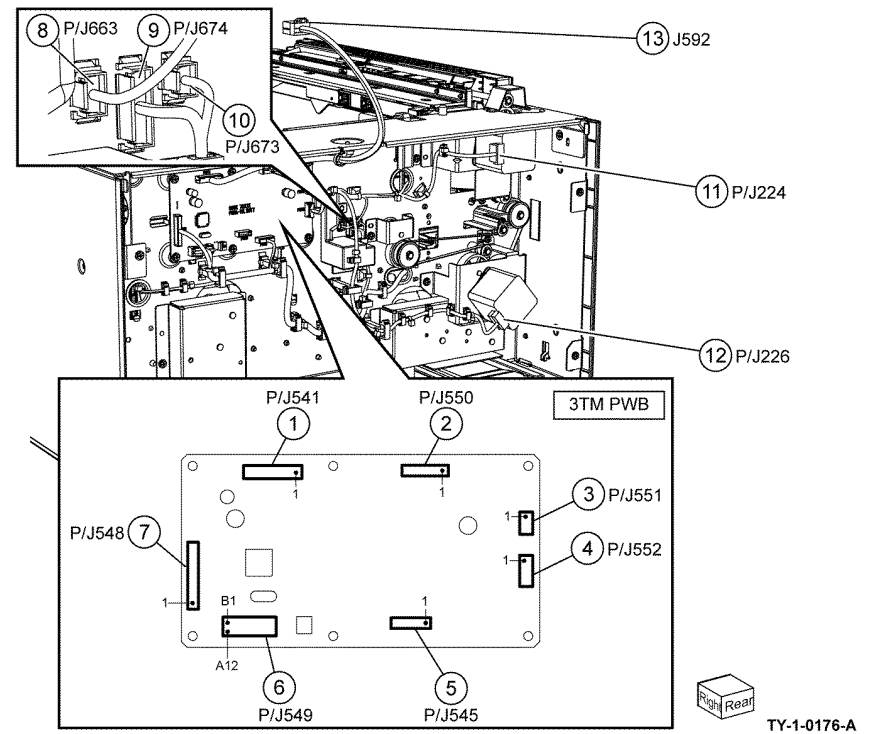
Figure 22 Tray Module (TTM) (1 of 3)

Tray Module (TTM) (1 of 3)

Location: PL 70.65

P/J671	Figure 20	13	Connector (9 pin) (3TM)
P/J671	Figure 23	8	Connector (9 pin) (TTM)
P/J673	Figure 20	11	Connector (9 pin) (3TM)
P/J673	Figure 22	1	Connector (9 pin) (TTM)
P/J674	Figure 22	9	Connector (3 pin) (TTM)
P/J675	Figure 18	10	Connector (3 pin) (1TM)
P/J675	Figure 20	16	Connector (3 pin) (3TM)
P/J675	Figure 23	5	Connector (3 pin) (TTM)
J678	Figure 35	10	HCF
J690	Figure 17	1	Connector (STM)
P/J700	Figure 3	7	CCD assembly
P/J750	Figure 10	4	ESS PWB
P/J751	Figure 2	7	DADF PWB
P/J752	Figure 2	4	DADF PWB
P/J753	Figure 2	5	DADF PWB
P/J754	Figure 2	6	DADF PWB (option)
P/J755	Figure 2	3	DADF PWB
P/J756	Figure 2	2	DADF PWB

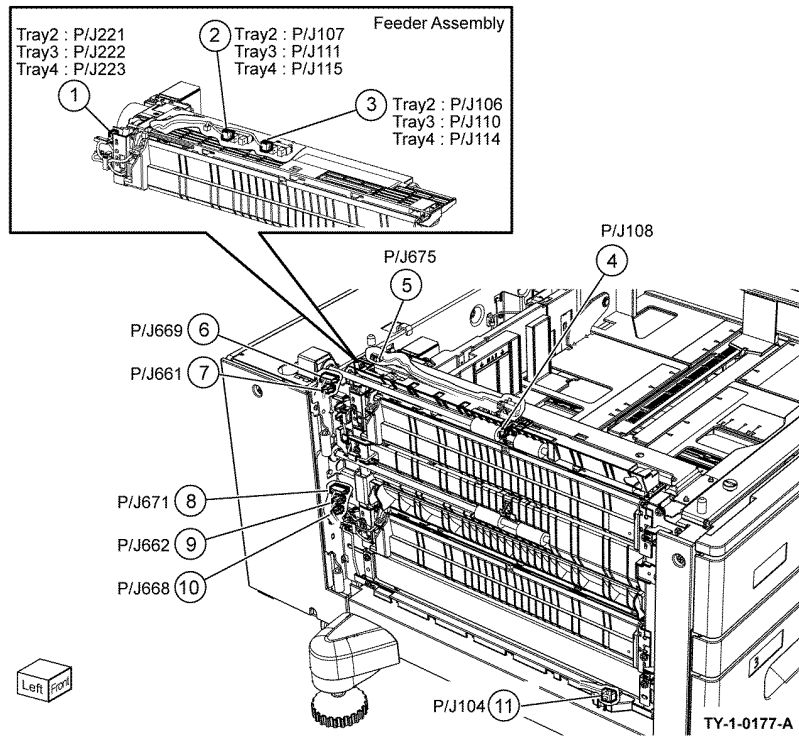
Figure 23 Tray module (TTM) (2 of 3)

Tray Module (TTM) (2 of 3)

Location: PL 70.65

P/J No	Figure No.	Item No.	PJ Location
P/J604	Figure 9	5	Connector (9 pin)
P/J605	Figure 9	6	Connector (4 pin)
P/J606	Figure 13	8	Connector (4 pin)
DP612	Figure 7	1	Fuser
DJ614	Figure 6	2	Drum cartridge
DP614A	Figure 6	5	Connector
DP614B	Figure 6	6	Connector
P/J614	Figure 13	11	Connector (3 pin)
P/J661	Figure 16	6	Connector (4 pin) (STM)
P/J661	Figure 18	8	Connector (4 pin) (1TM)
P/J661	Figure 20	14	Connector (4 pin) (3TM)
P/J661	Figure 23	6	Connector (4 pin) (TTM)
P/J662	Figure 20	12	Connector (4 pin) (3TM)
P/J662	Figure 23	9	Connector (4 pin) (TTM)
P/J663	Figure 20	10	Connector (4 pin) (3TM)
P/J663	Figure 22	8	Connector (4 pin) (TTM)
P/J668	Figure 18	7	Connector (2 pin) (1TM)
P/J668	Figure 20	9	Connector (2 pin) (3TM)
P/J668	Figure 23	10	Connector (2 pin) (TTM)
P/J669	Figure 16	7	Connector (9 pin) (STM)
P/J669	Figure 18	9	Connector (9 pin) (1TM)
P/J669	Figure 20	15	Connector (9 pin) (3TM)
P/J669	Figure 23	6	Connector (9 pin) (TTM)

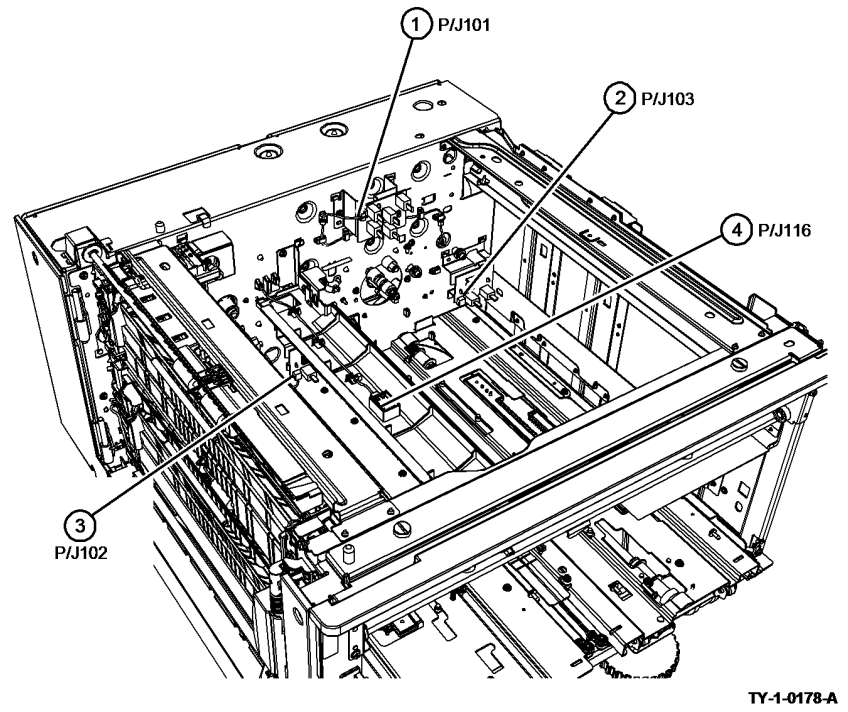
Figure 24 Tray module (TTM) (3 of 3)

Tray Module (TTM) (3 of 3)

Location: PL 70.65

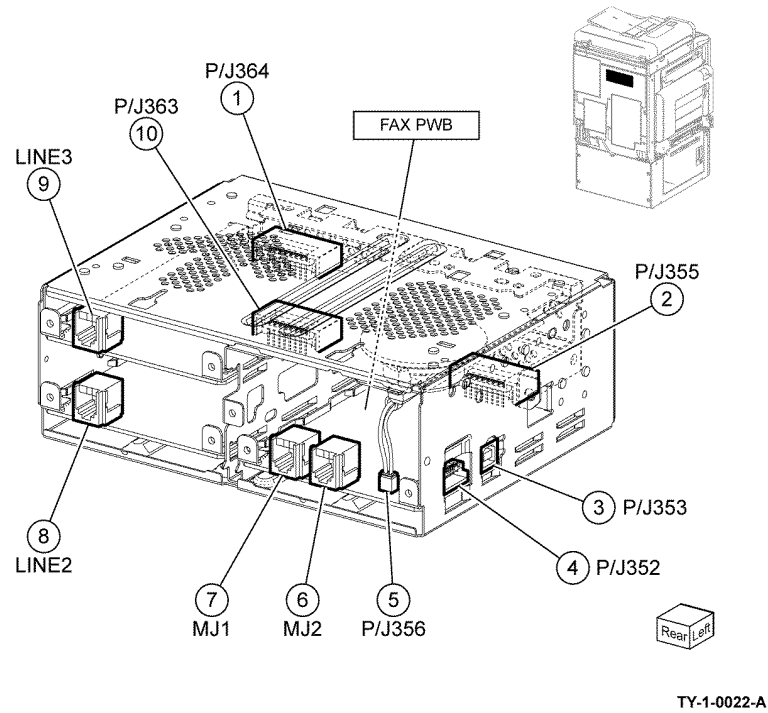
Figure 25 Fax PWB

Fax PWB

PL 20.05

P/J No	Figure No.	Item No.	PJ Location
F10	Figure 7	3	Thermostat center
F10	Figure 7	4	Thermostat front
FS001	Figure 35	3	HCF
FS002	Figure 35	3	HCF
FS003	Figure 35	8	HCF
FS004	Figure 35	8	HCF
K(K)	Figure 6	1	Print head assembly
LINE2	Figure 25	8	Line 2 fax PWB (option)
LINE3	Figure 25	9	Line 3 fax PWB (option)
MJ1	Figure 25	7	Line 1 fax PWB (LINE)
MJ2	Figure 25	6	Line 1 fax PWB (TEL)
T1	Figure 2	16	Terminal
T1	Figure 14	14	Terminal
T2	Figure 2	15	Terminal
T2	Figure 14	15	Terminal
T3	Figure 2	13	Terminal
T4	Figure 2	14	Terminal
USB	Figure 4	4	USB

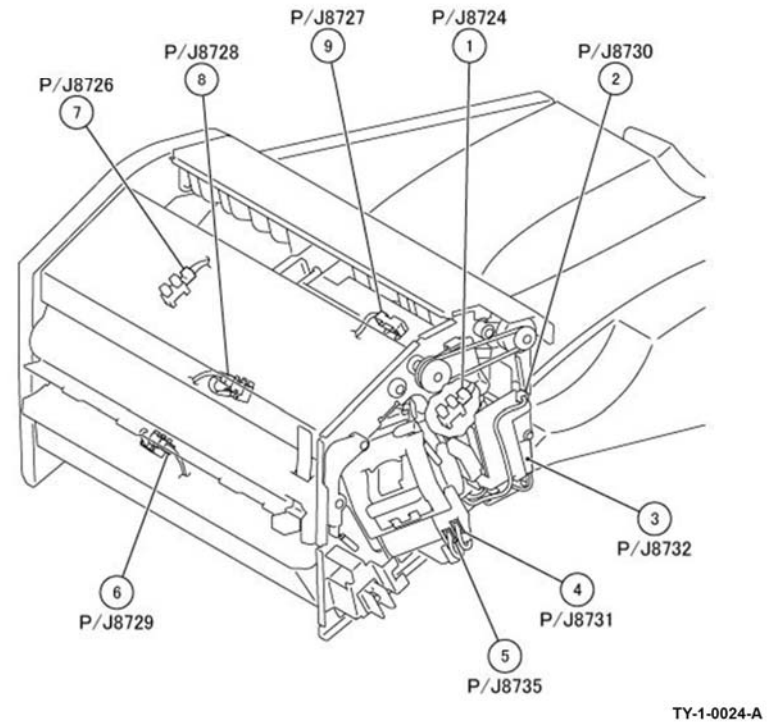
Figure 26 Integrated office finisher (1 of 3)

Integrated Office Finisher (1 of 3)

Location: PL 12.06

P/J No	Figure No.	Item No.	PJ Location
P/J8700	Figure 27	2	Integrated office finisher
P/J8701	Figure 27	1	Integrated office finisher
P/J8702	Figure 27	11	Integrated office finisher
P/J8703	Figure 27	10	Integrated office finisher
P/J8704	Figure 27	13	Integrated office finisher
P/J8705	Figure 27	12	Integrated office finisher
P/J8706	Figure 27	8	Integrated office finisher
P/J8707	Figure 27	3	Integrated office finisher
P/J8708	Figure 27	17	Integrated office finisher
P/J8709	Figure 27	16	Integrated office finisher
P/J8710	Figure 27	9	Integrated office finisher
P/J8711	Figure 27	4	Integrated office finisher
P/J8721	Figure 28	2	Integrated office finisher
P/J8722	Figure 28	1	Integrated office finisher
P/J8723	Figure 28	6	Integrated office finisher
P/J8724	Figure 26	1	Integrated office finisher
P/J8725	Figure 28	11	Integrated office finisher
P/J8726	Figure 26	7	Integrated office finisher
P/J8727	Figure 26	9	Integrated office finisher

P/J8728	Figure 26	8	Integrated office finisher
P/J8729	Figure 26	6	Integrated office finisher
P/J8730	Figure 26	2	Integrated office finisher
P/J8731	Figure 26	4	Integrated office finisher

P/J No	Figure No.	Item No.	PJ Location
P/J8732	Figure 26	3	Integrated office finisher
P/J8733	Figure 27	14	Integrated office finisher
P/J8734	Figure 27	15	Integrated office finisher
P/J8735	Figure 26	5	Integrated office finisher
P/J8736	Figure 28	5	Integrated office finisher
J8737	Figure 28	9	Integrated office finisher
J8738	Figure 28	10	Integrated office finisher
P/J8739	Figure 27	7	Integrated office finisher
P/J8740	Figure 27	5	Integrated office finisher
P/J8741	Figure 27	6	Integrated office finisher
J8742A	Figure 28	7	Integrated office finisher
J8742B	Figure 28	8	Integrated office finisher

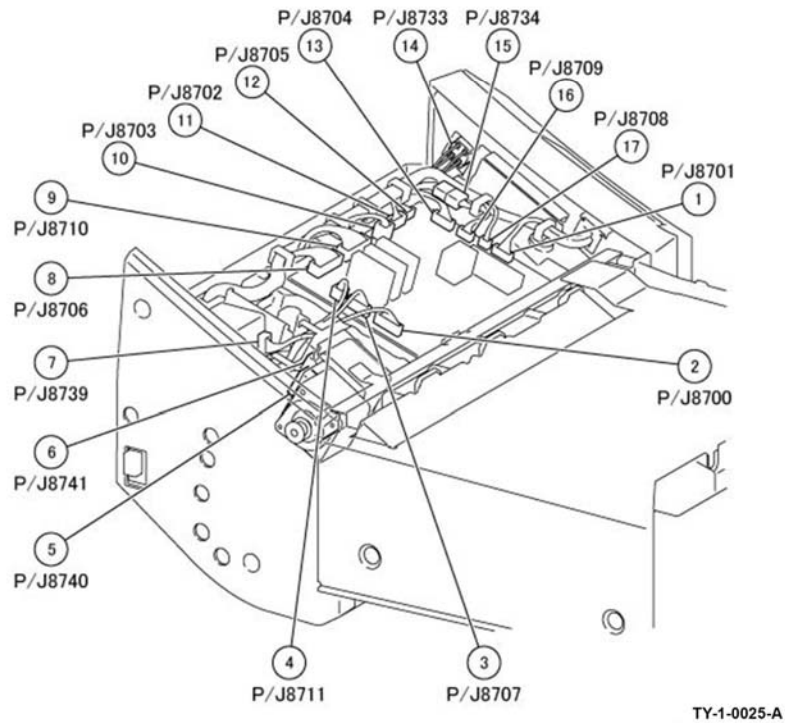
Figure 27 Integrated office finisher (2 of 3)

Integrated Office Finisher (2 of 3)

Location: PL 12.06

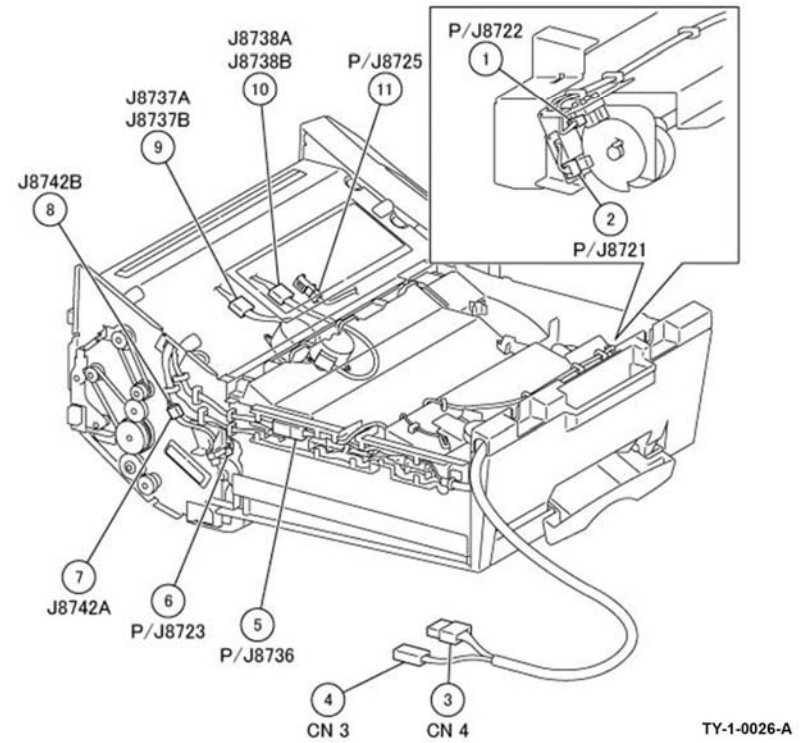
Figure 28 Integrated office finisher (3 of 3)

Integrated Office Finisher (3 of 3)

Location: PL 12.06

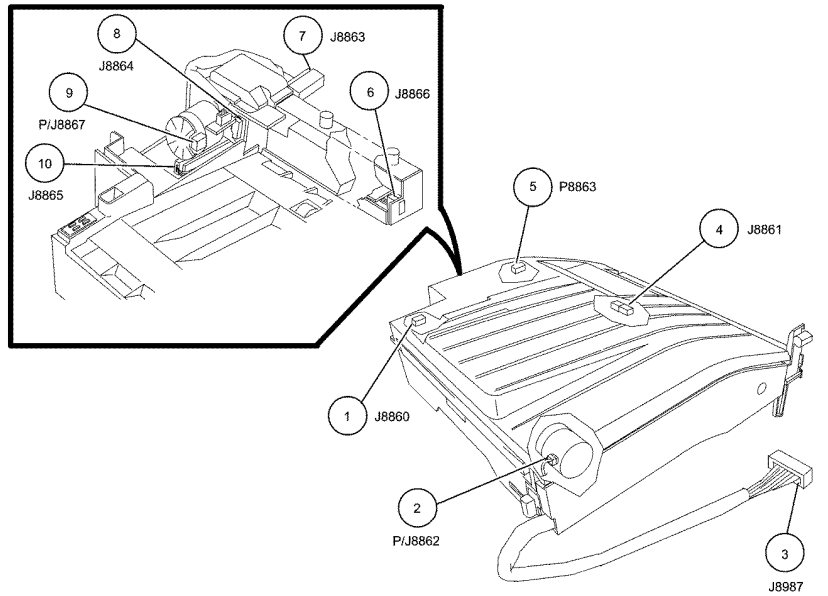
Figure 29 Horizontal transport

Horizontal Transport

Location: [PL 13.06](#)

P/J No	Figure No.	Item No.	PJ Location
J8860	Figure 29	1	Horizontal transport
J8861	Figure 29	4	Horizontal transport
P/J8862	Figure 29	2	Horizontal transport
J8863	Figure 29	7	Horizontal transport
P8863	Figure 29	5	Horizontal transport
J8864	Figure 29	8	Horizontal transport
J8865	Figure 29	10	Horizontal transport
J8866	Figure 29	6	Horizontal transport
P/J8867	Figure 29	9	Horizontal transport
J8868	Figure 32	4	Office finisher LX
J8869	Figure 32	3	Office finisher LX
J8870	Figure 31	24	Office finisher LX
J8871	Figure 31	23	Office finisher LX
J8872	Figure 31	21	Office finisher LX
J8873	Figure 31	2	Office finisher LX
J8874	Figure 31	1	Office finisher LX
J8875	Figure 31	22	Office finisher LX
P/J8876	Figure 32	5	Office finisher LX
P/J8877	Figure 31	20	Office finisher LX
P/J8878	Figure 31	7	Office finisher LX
P/J8879	Figure 31	5	Office finisher LX
J8880	Figure 32	7	Office finisher LX
J8881	Figure 32	11	Office finisher LX

J8982	Figure 31	18	Office finisher LX
P/J8983	Figure 31	9	Office finisher LX
J8984	Figure 31	6	Office finisher LX
J8985	Figure 34	4	Booklet maker
P8985	Figure 31	17	Office finisher LX
P/J8986	Figure 31	8	Office finisher LX
J8987	Figure 29	3	Horizontal transport
P8987	Figure 31	16	Office finisher LX
P/J8988	Figure 31	11	Office finisher LX
J8989	Figure 31	13	Office finisher LX
P/J8990	Figure 31	12	Office finisher LX
P/J8991	Figure 34	9	Booklet maker
P/J8992	Figure 34	7	Booklet maker
P/J8993	Figure 34	6	Booklet maker
P/J8994	Figure 34	5	Booklet maker
P/J8995	Figure 34	8	Booklet maker

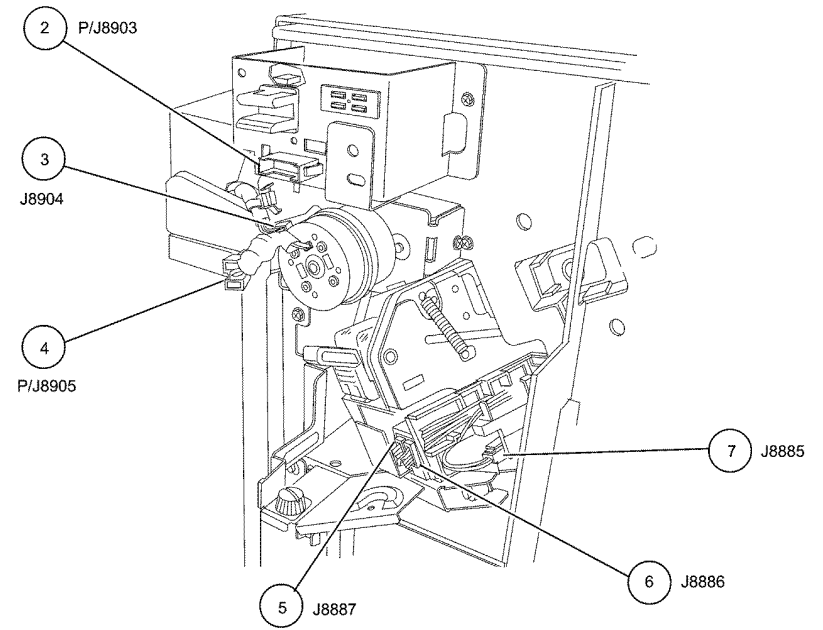
Figure 30 Office finisher LX (1 of 3)

Office Finisher LX (1 of 3)

Location: [PL 13.10](#)

P/J No	Figure No.	Item No.	PJ Location
P/J8884	Figure 32	10	Office finisher LX
J8885	Figure 30	7	Office Finisher LX
J8886	Figure 30	6	Office Finisher LX
J8887	Figure 30	5	Office Finisher LX
P/J8888	Figure 32	9	Office finisher LX
J8889	Figure 31	3	Office finisher LX
J8890	Figure 31	4	Office finisher LX
J8891	Figure 32	2	Office finisher LX
P/J8892	Figure 33	1	Booklet maker
P/J8893	Figure 33	2	Booklet maker
J8894	Figure 34	3	Booklet maker
J8895	Figure 34	3	Booklet maker
P/J8896	Figure 33	7	Booklet maker
J8897	Figure 33	4	Booklet maker
J8898	Figure 33	5	Booklet maker
J8899	Figure 33	6	Booklet maker
J8900	Figure 33	8	Booklet maker
J8901	Figure 33	3	Booklet maker
P8903	Figure 32	1	Office finisher LX
P/J8903	Figure 30	2	Office Finisher LX
J8904	Figure 30	3	Office Finisher LX
P/J8905	Figure 30	4	Office Finisher LX
P/J8906	Figure 34	2	Booklet maker
J8980	Figure 31	19	Office finisher LX
P/J8981	Figure 31	10	Office finisher LX

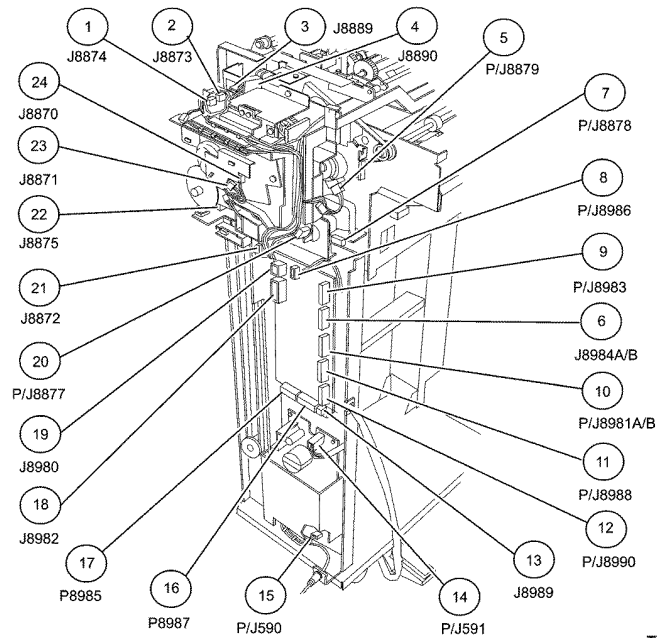
Figure 31 Office finisher LX (2 of 3)

Office Finisher LX (2 of 3)

Location: [PL 13.10](#)

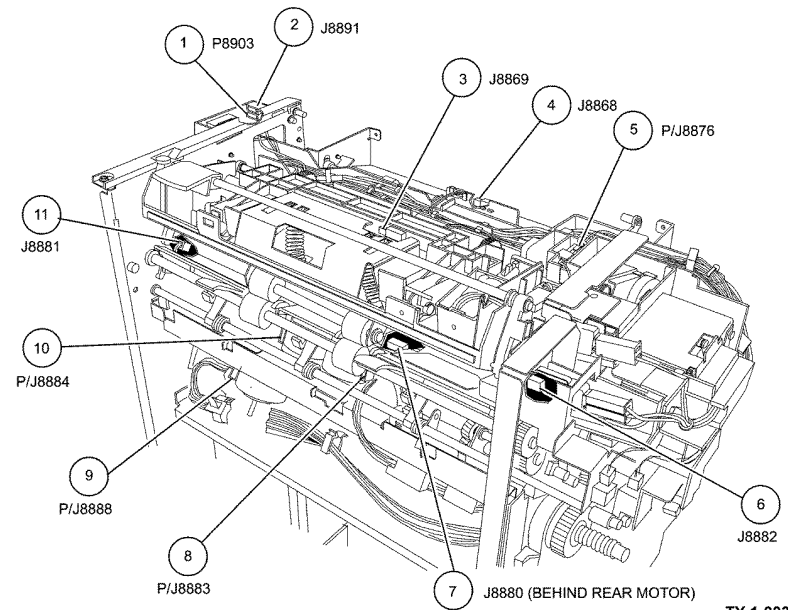
Figure 32 Office finisher LX (3 of 3)

Office Finisher LX (3 of 3)

Location: [PL 13.10](#)

J8882	Figure 32	6	Office finisher LX
P/J8883	Figure 32	8	Office finisher LX

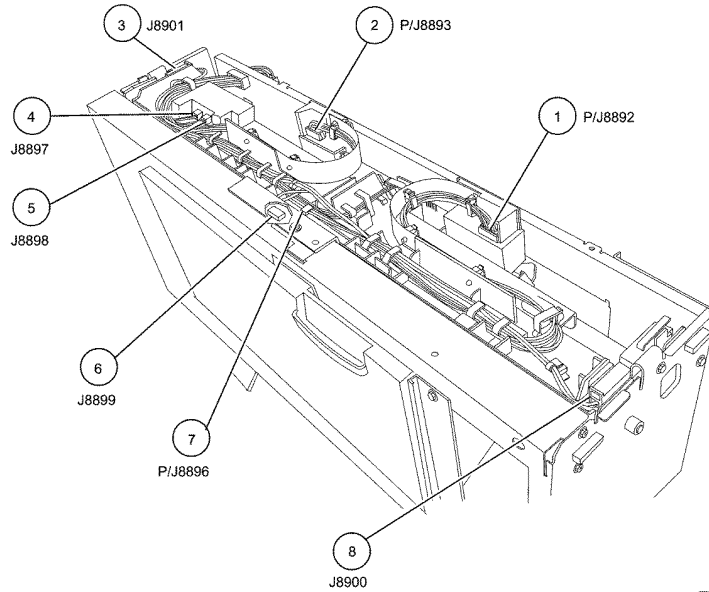
Figure 33 Booklet maker (1 of 2)

Booklet Maker (1 of 2)

Location: PL 13.50

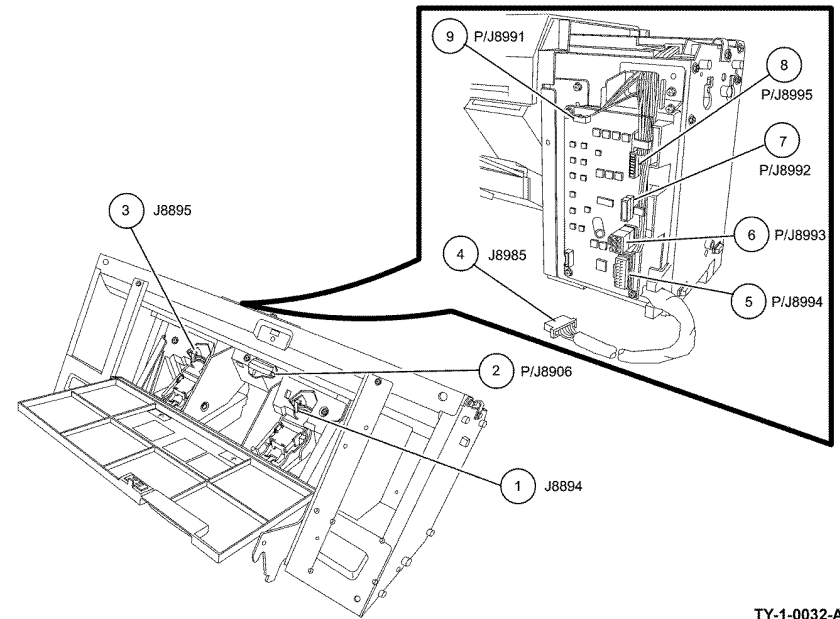
Figure 34 Booklet maker (2 of 2)

Booklet Maker (2 of 2)

Location: PL 13.50

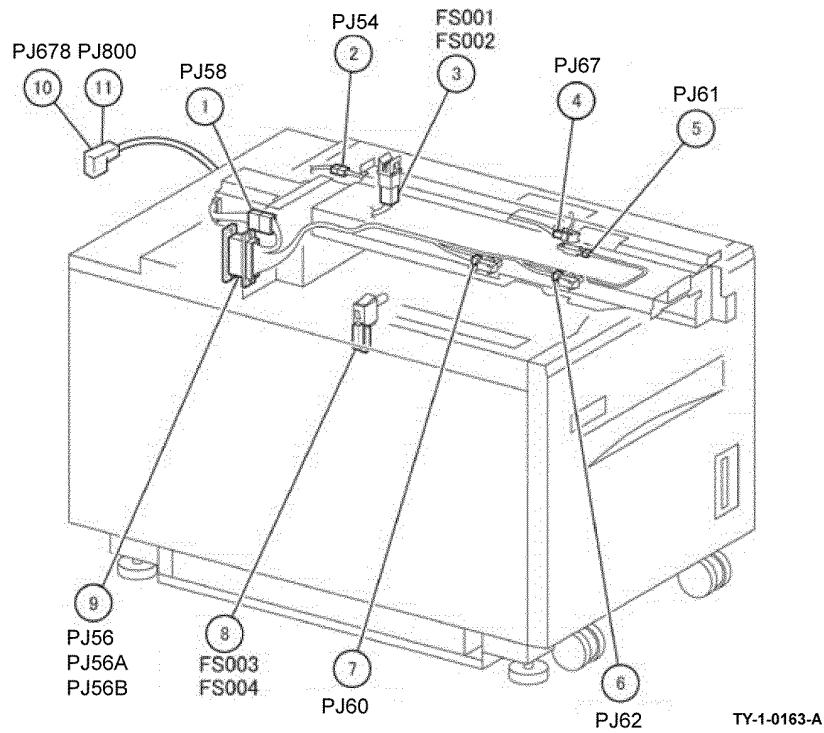
Figure 35 HCF (1 of 2)

HCF (1 of 2)

Location: PL 70.50

P/J No	Figure No.	Item No.	PJ Location
P/J60	Figure 35	7	HCF
P/J61	Figure 35	5	HCF
P/J62	Figure 35	6	HCF
P/J67	Figure 35	4	HCF

P/J No	Figure No.	Item No.	PJ Location
P/J757	Figure 2	1	DADF PWB
DP800	Figure 14	9	Connector
J800	Figure 35	11	HCF
P/J1332	Figure 10	24	ESS PWB
P/J1334	Figure 10	15	ESS PWB
P/J1352	Figure 10	2	ESS PWB
P/J1363	Figure 10	16	ESS PWB
P/J1365	Figure 10	9	ESS PWB
P/J7001	Figure 3	5	Lamp assembly
P/J7251	Figure 3	2	Platen close sensor
P/J7252	Figure 3	1	Platen angle sensor
P/J7253	Figure 3	4	IIT registration sensor
P/J7254	Figure 3	8	APS sensor 1
P/J7255	Figure 3	10	APS sensor 3

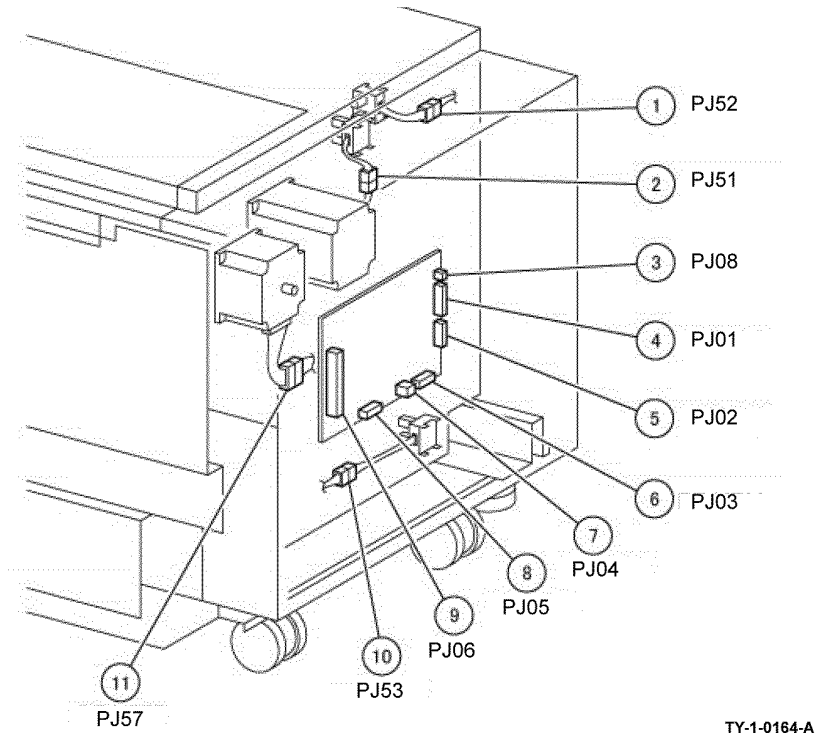
Figure 36 HCF (2 of 2)

HCF (2 of 2)

Location: PL 70.50

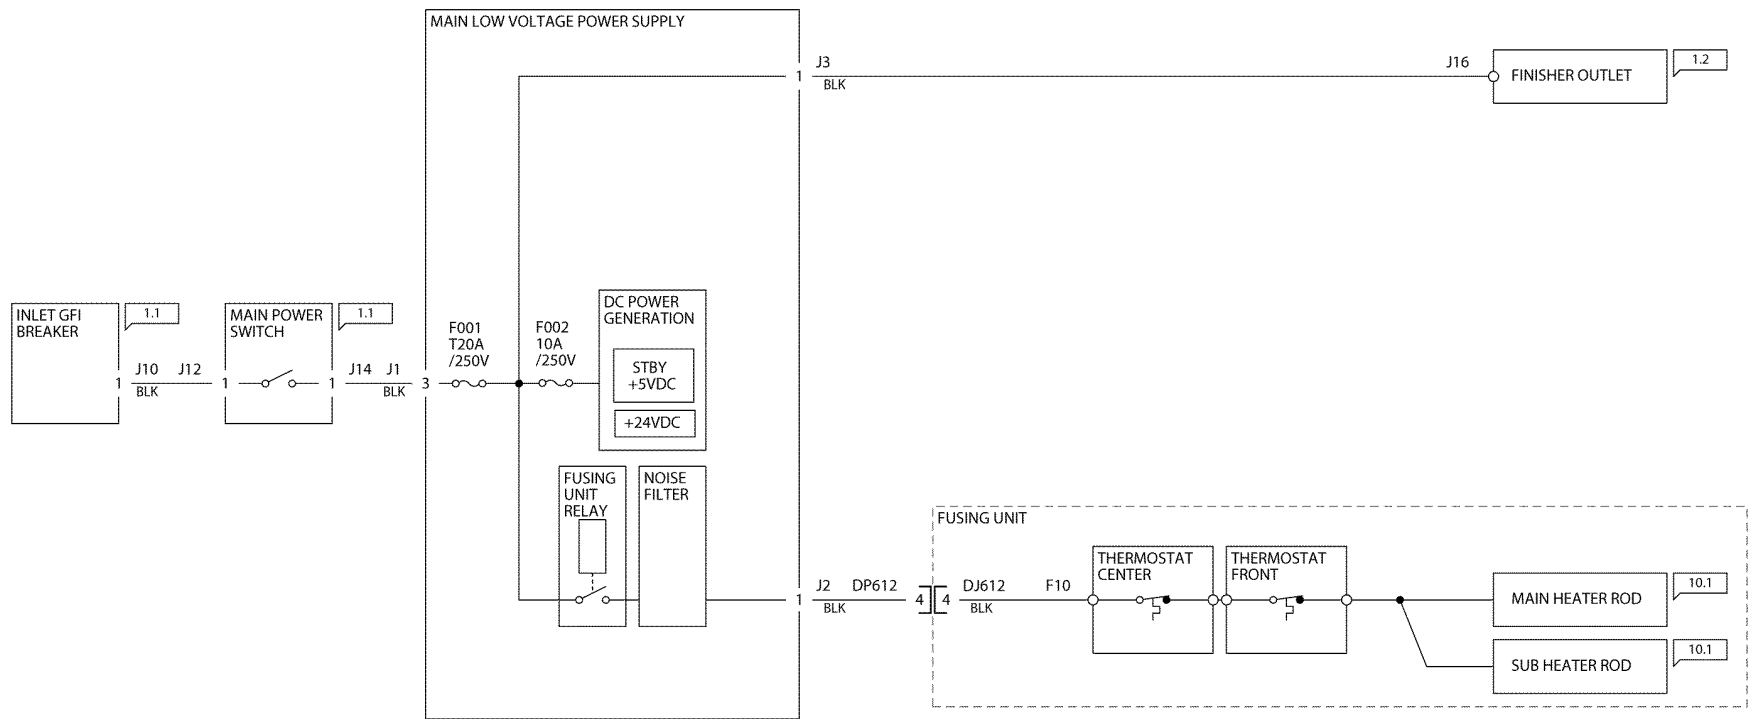
Figure 1 Wiring diagram 1

Wiring Diagram 1 IOT/IIT ACH

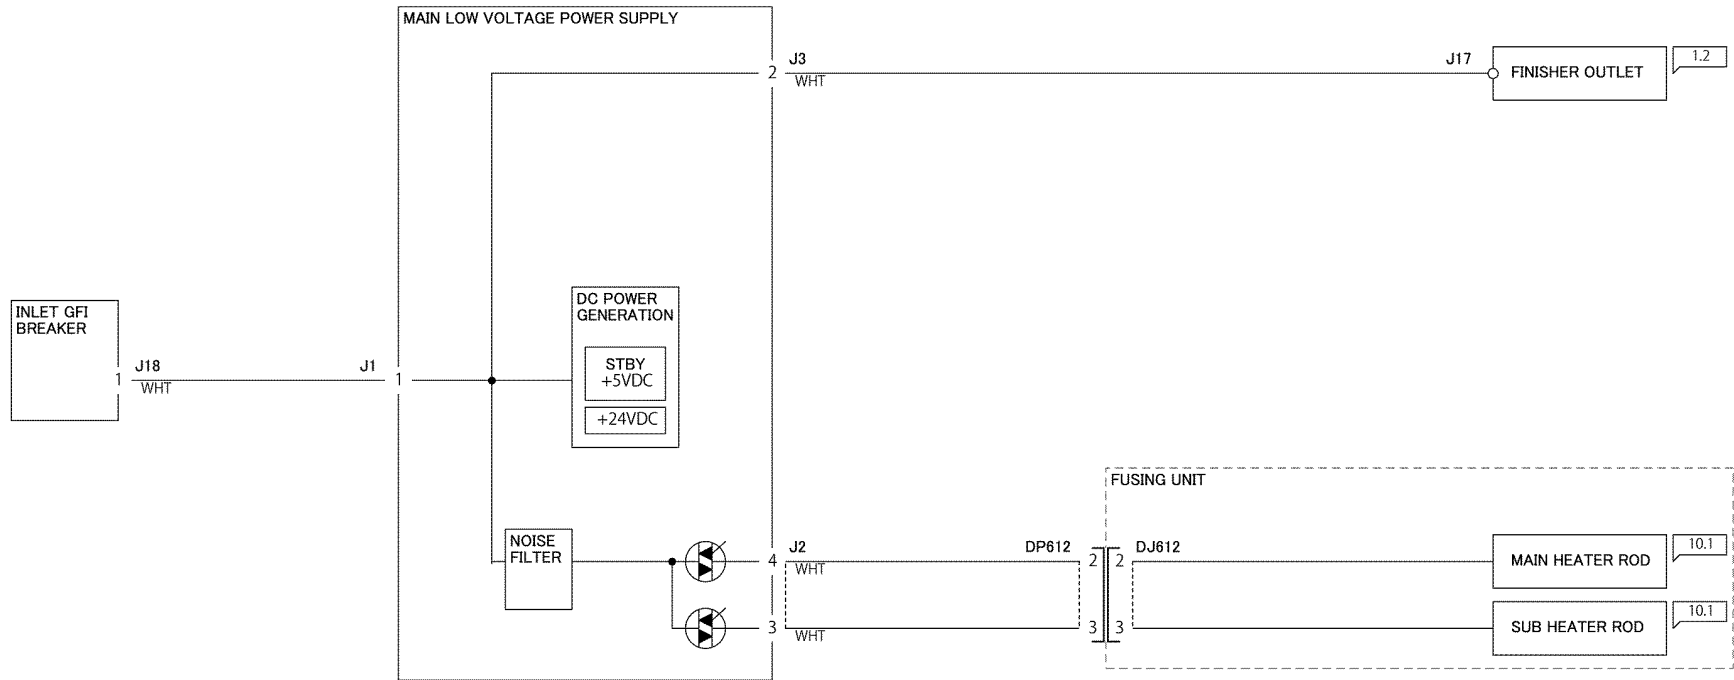
Figure 2 Wiring diagram 2

Wiring Diagram 2 IOT/IIT ACN

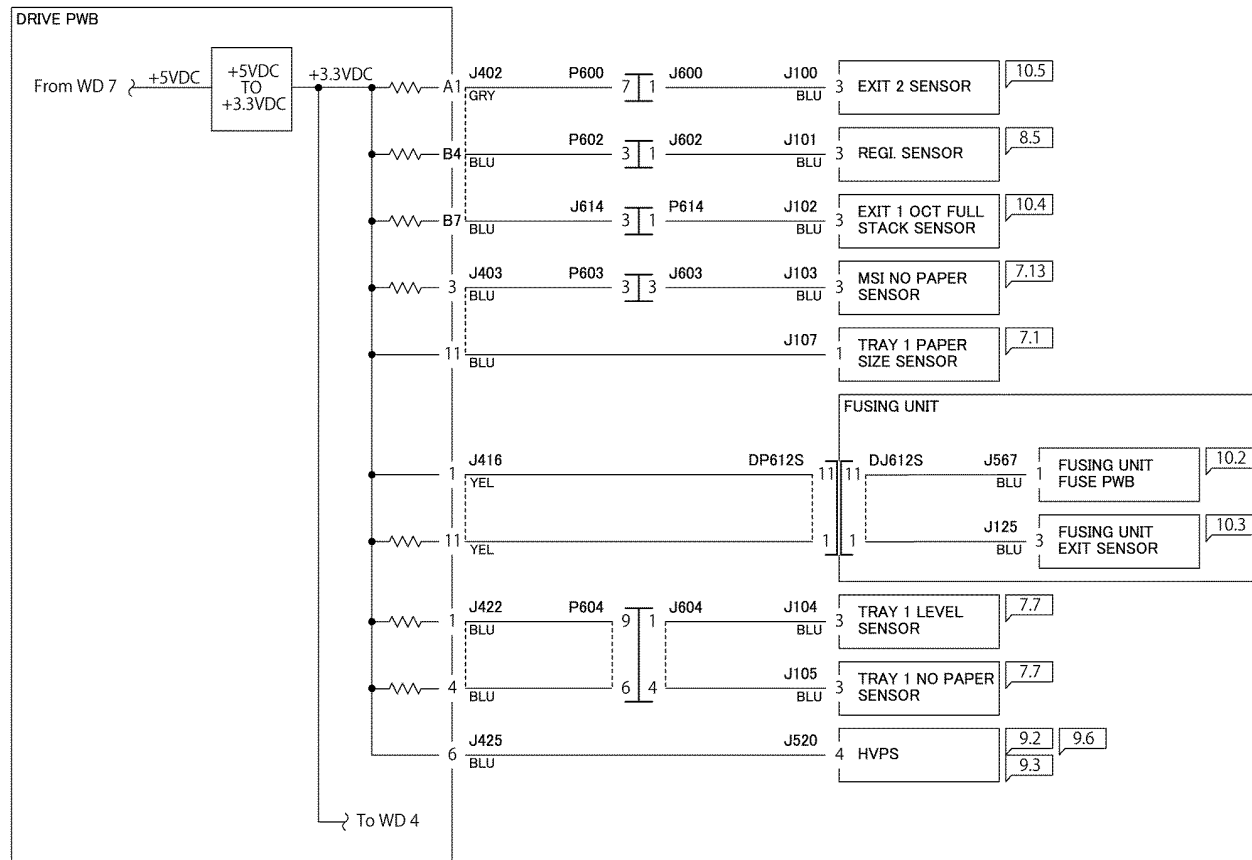
Figure 3 Wiring diagram 3

Wiring Diagram 3 IOT/IIT +3.3VDC (1 of 2)

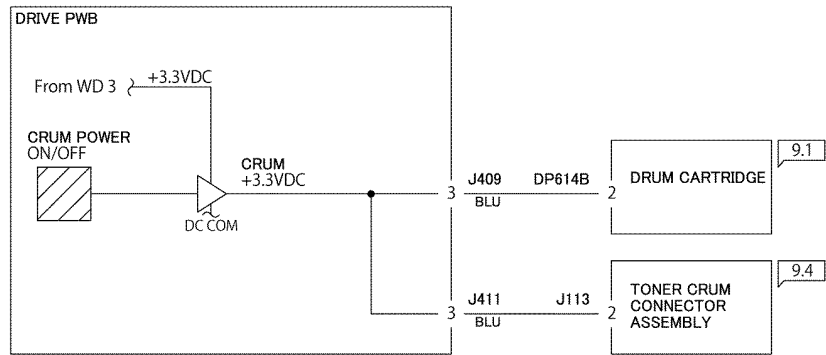
Figure 4 Wiring diagram 4

Wiring Diagram 4 IOT/IIT +3.3VDC (2 of 2)

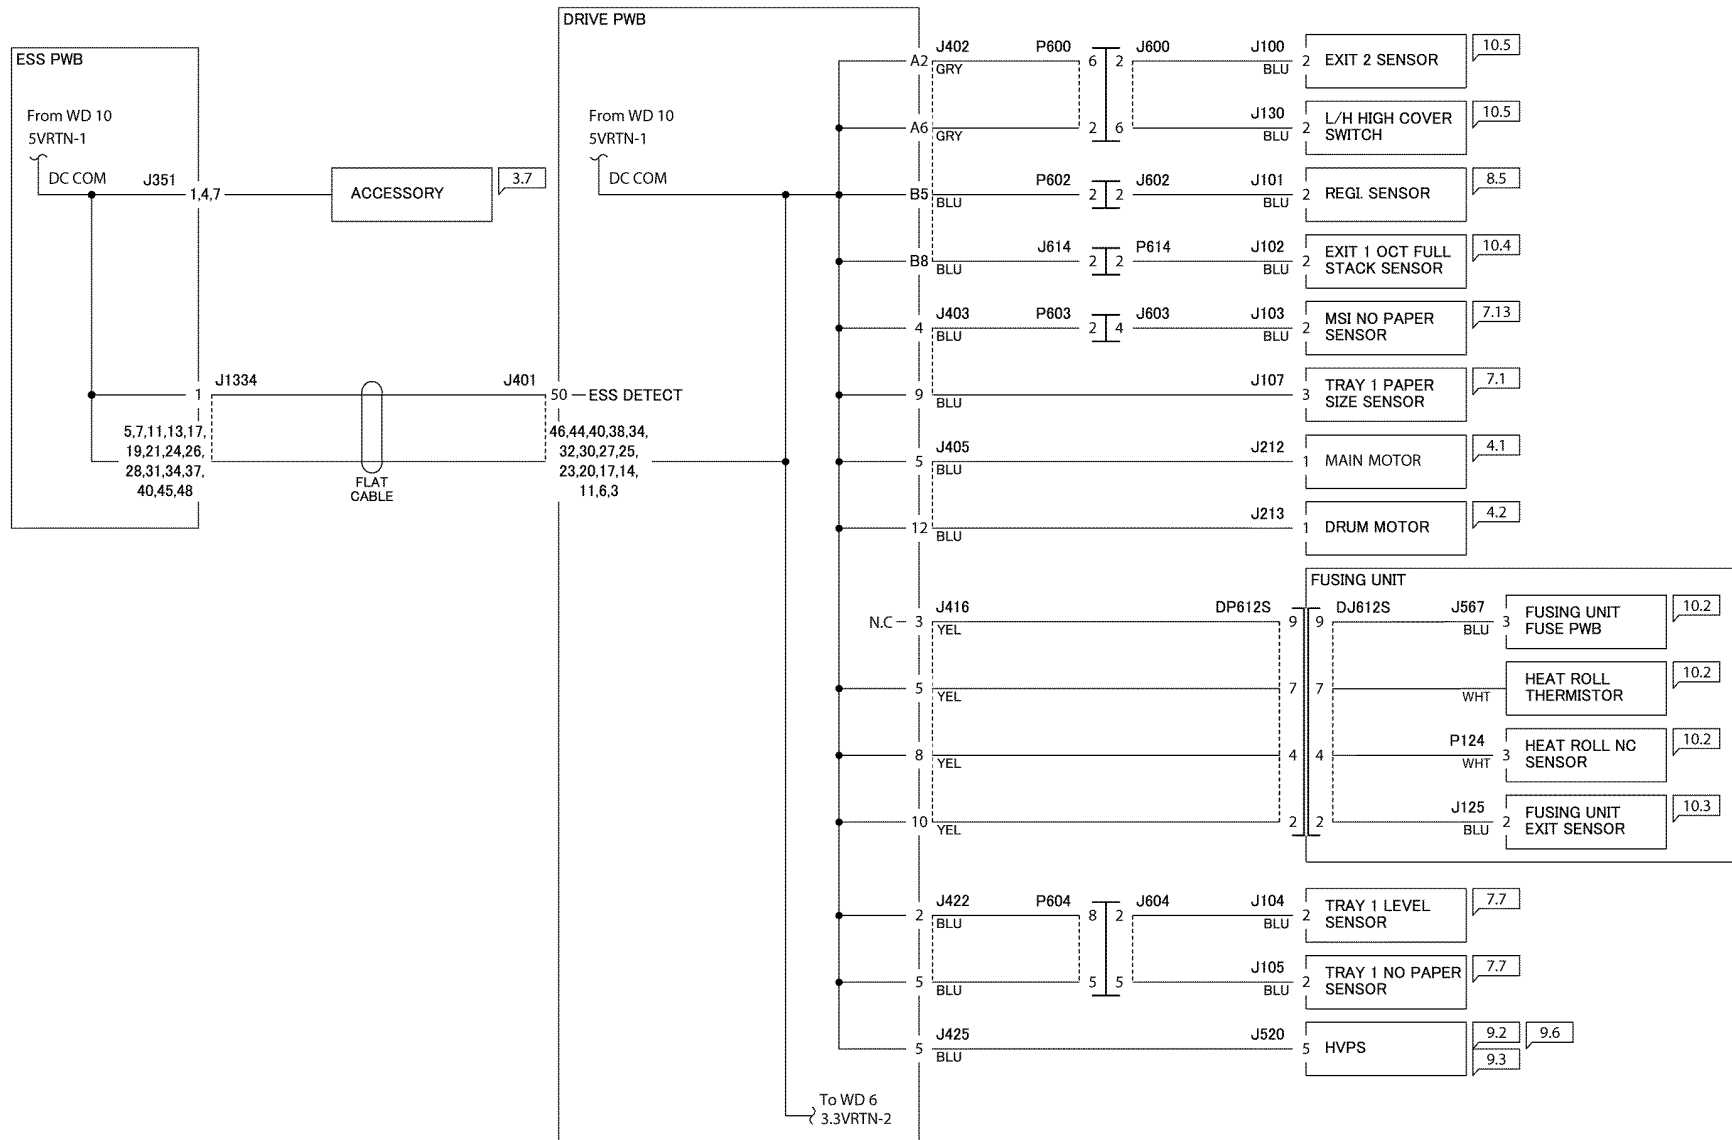
Figure 5 Wiring diagram 5

Wiring Diagram 5 IOT/IIT +3.3V RTN (1 of 2)

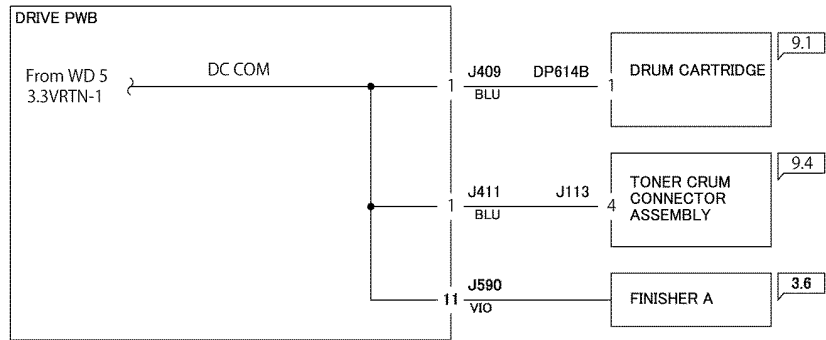
Figure 6 Wiring diagram 6

Wiring Diagram 6 IOT/IIT +3.3V RTN (2 of 2)

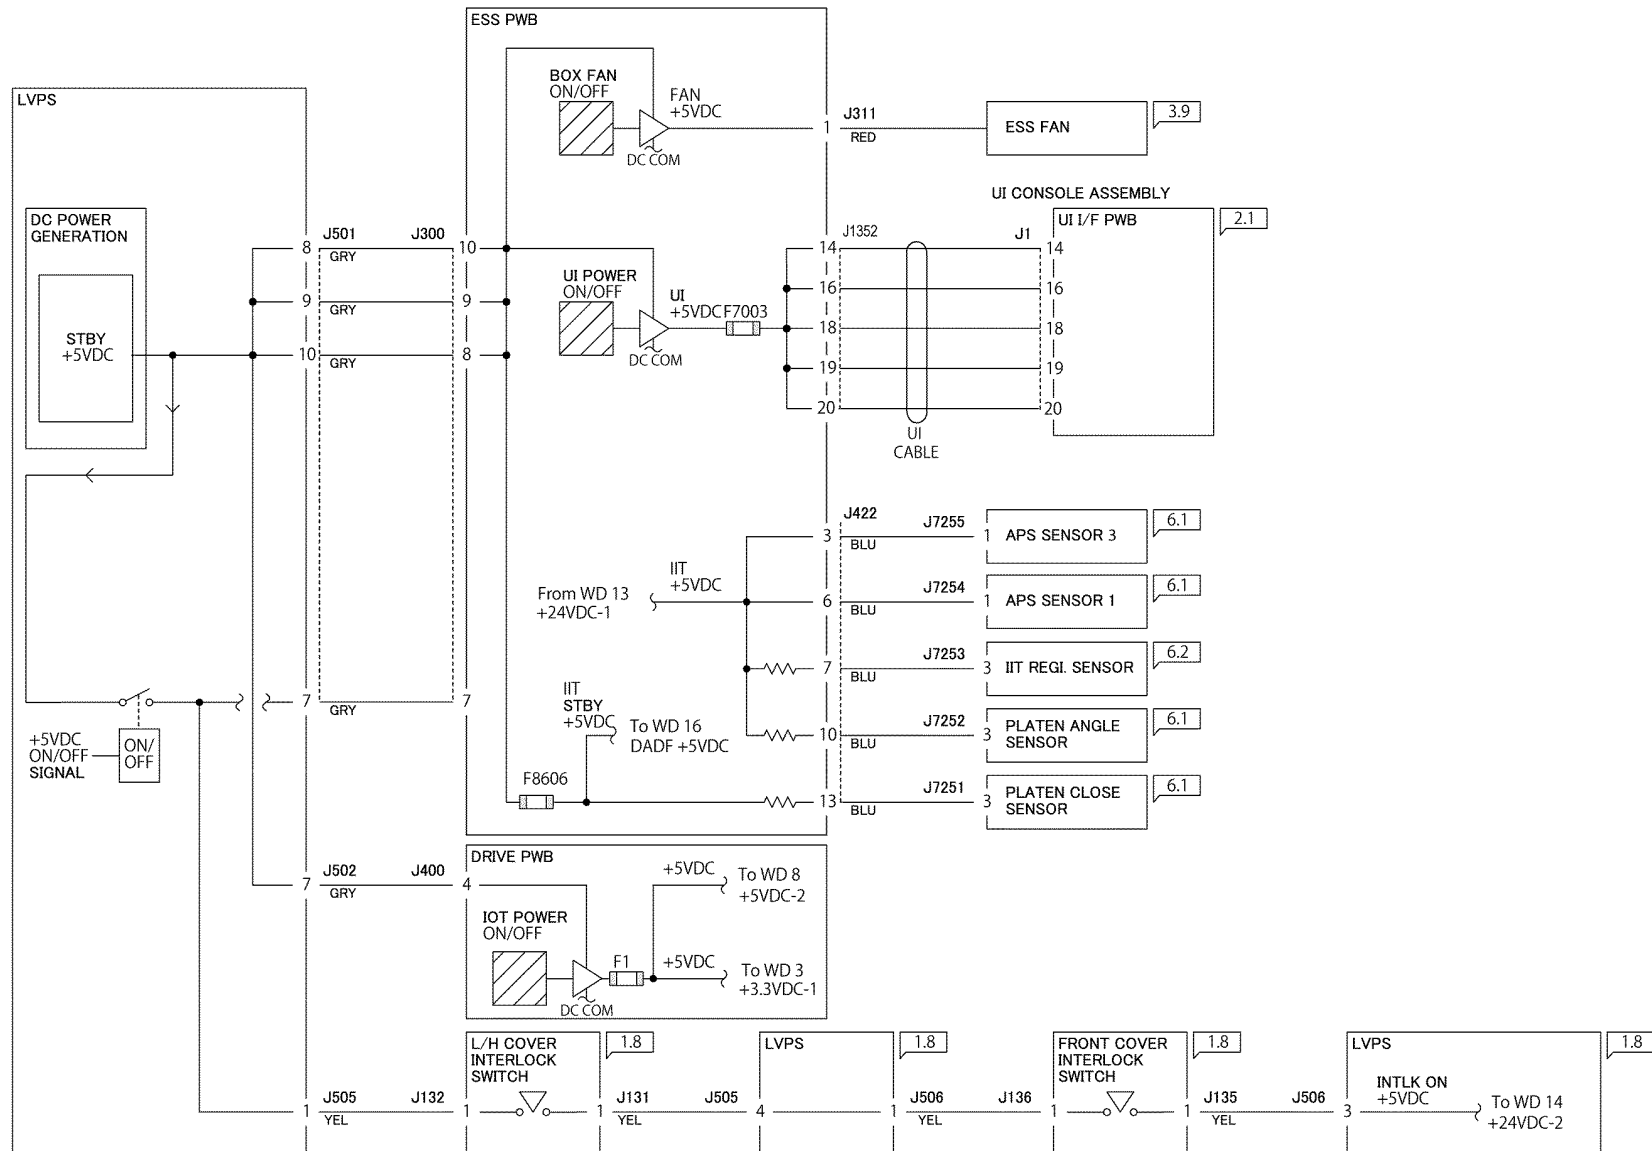
Figure 7 Wiring diagram 7

Wiring Diagram 7 IOT/IIT +5VDC (1 of 3)

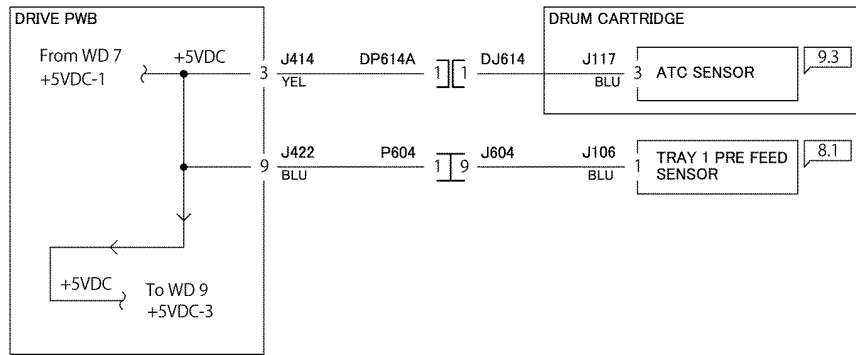
Figure 8 Wiring diagram 8

Wiring Diagram 8 IOT/IIT +5VDC (2 of 3)

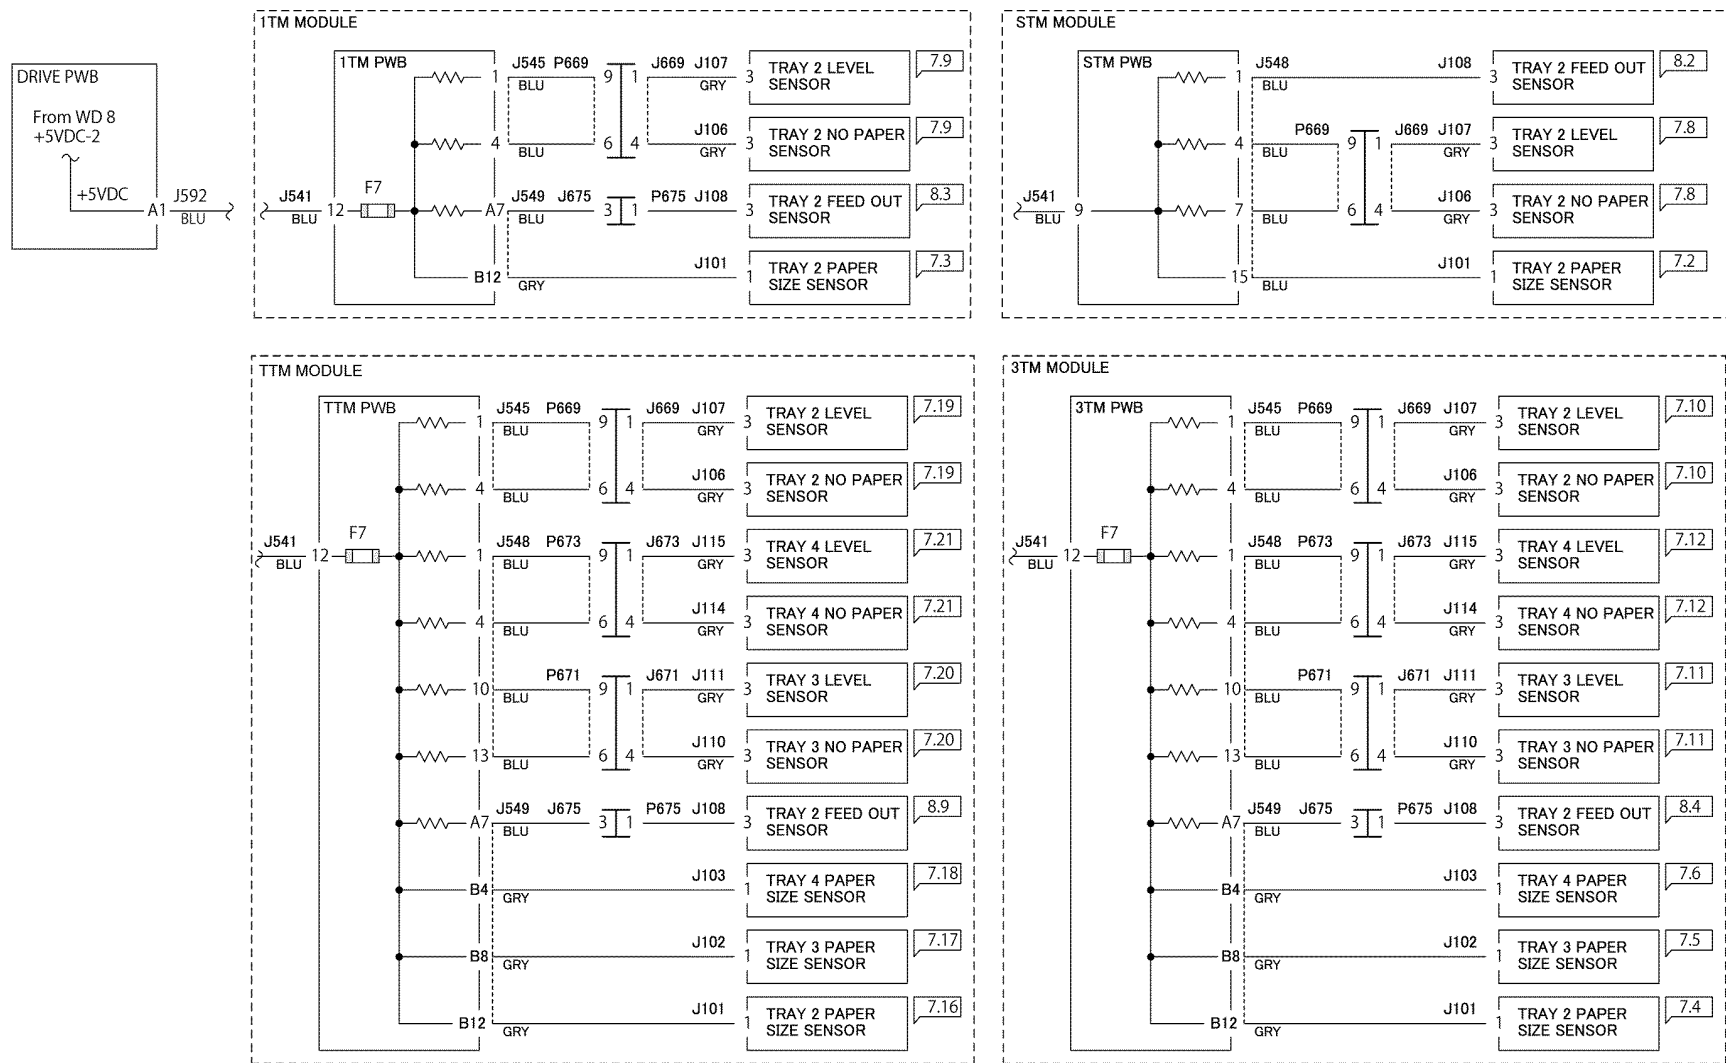
Figure 9 Wiring diagram 9

Wiring Diagram 9 IOT/IIT +5VDC (3 of 3)

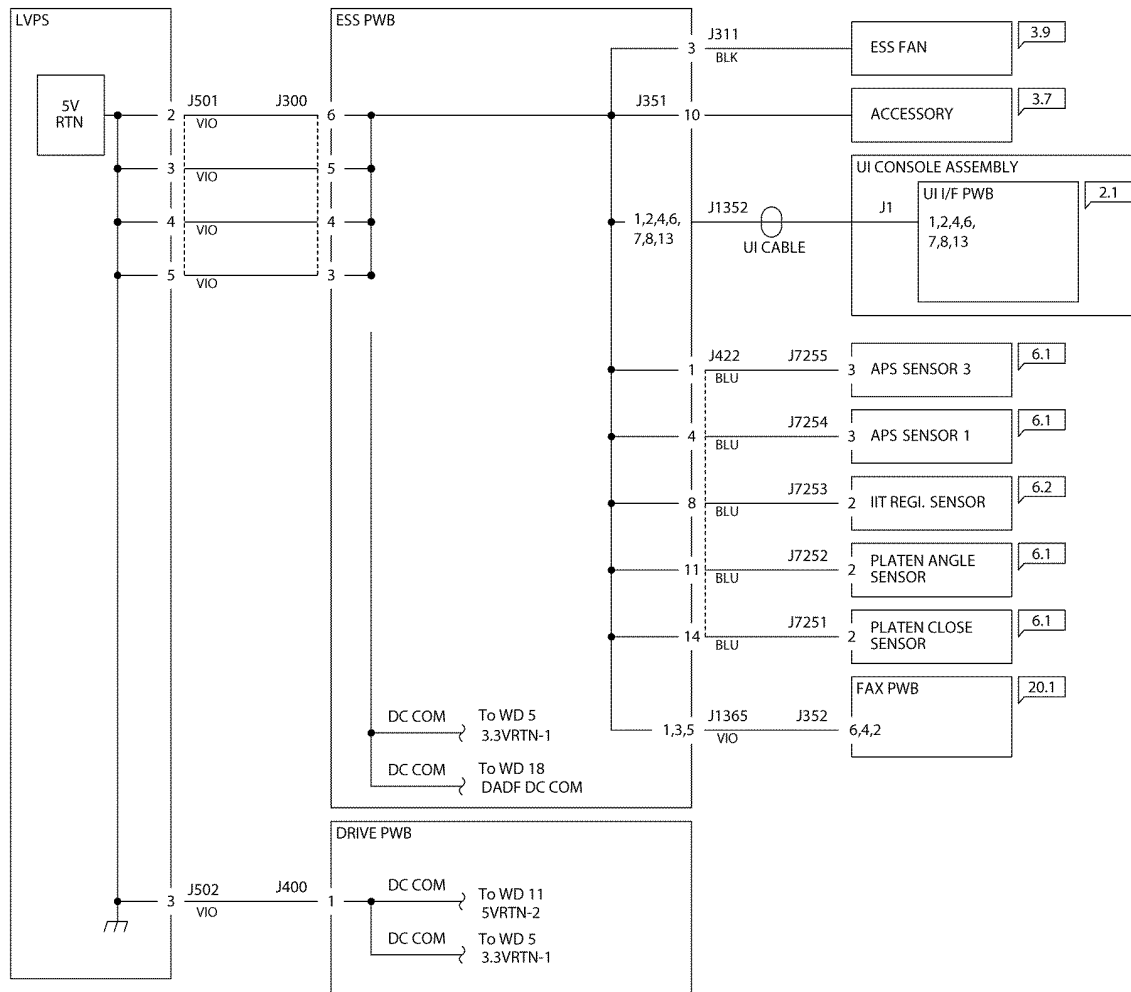
Figure 10 Wiring diagram 10

Wiring Diagram 10 IOT/IIT +5V RTN (1 of 3)

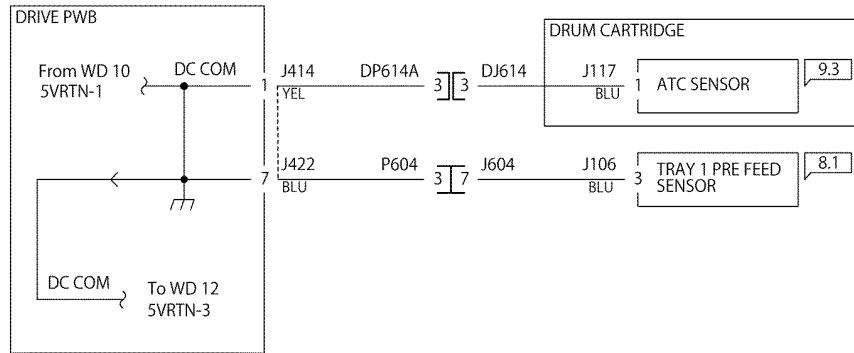
Figure 11 Wiring diagram 11

Wiring Diagram 11 IOT/IIT +5V RTN (2 of 3)
