708P91370
April 2017

Xerox® VersaLink® B7025/B7030/B7035 Multifunction Printer Service Manual

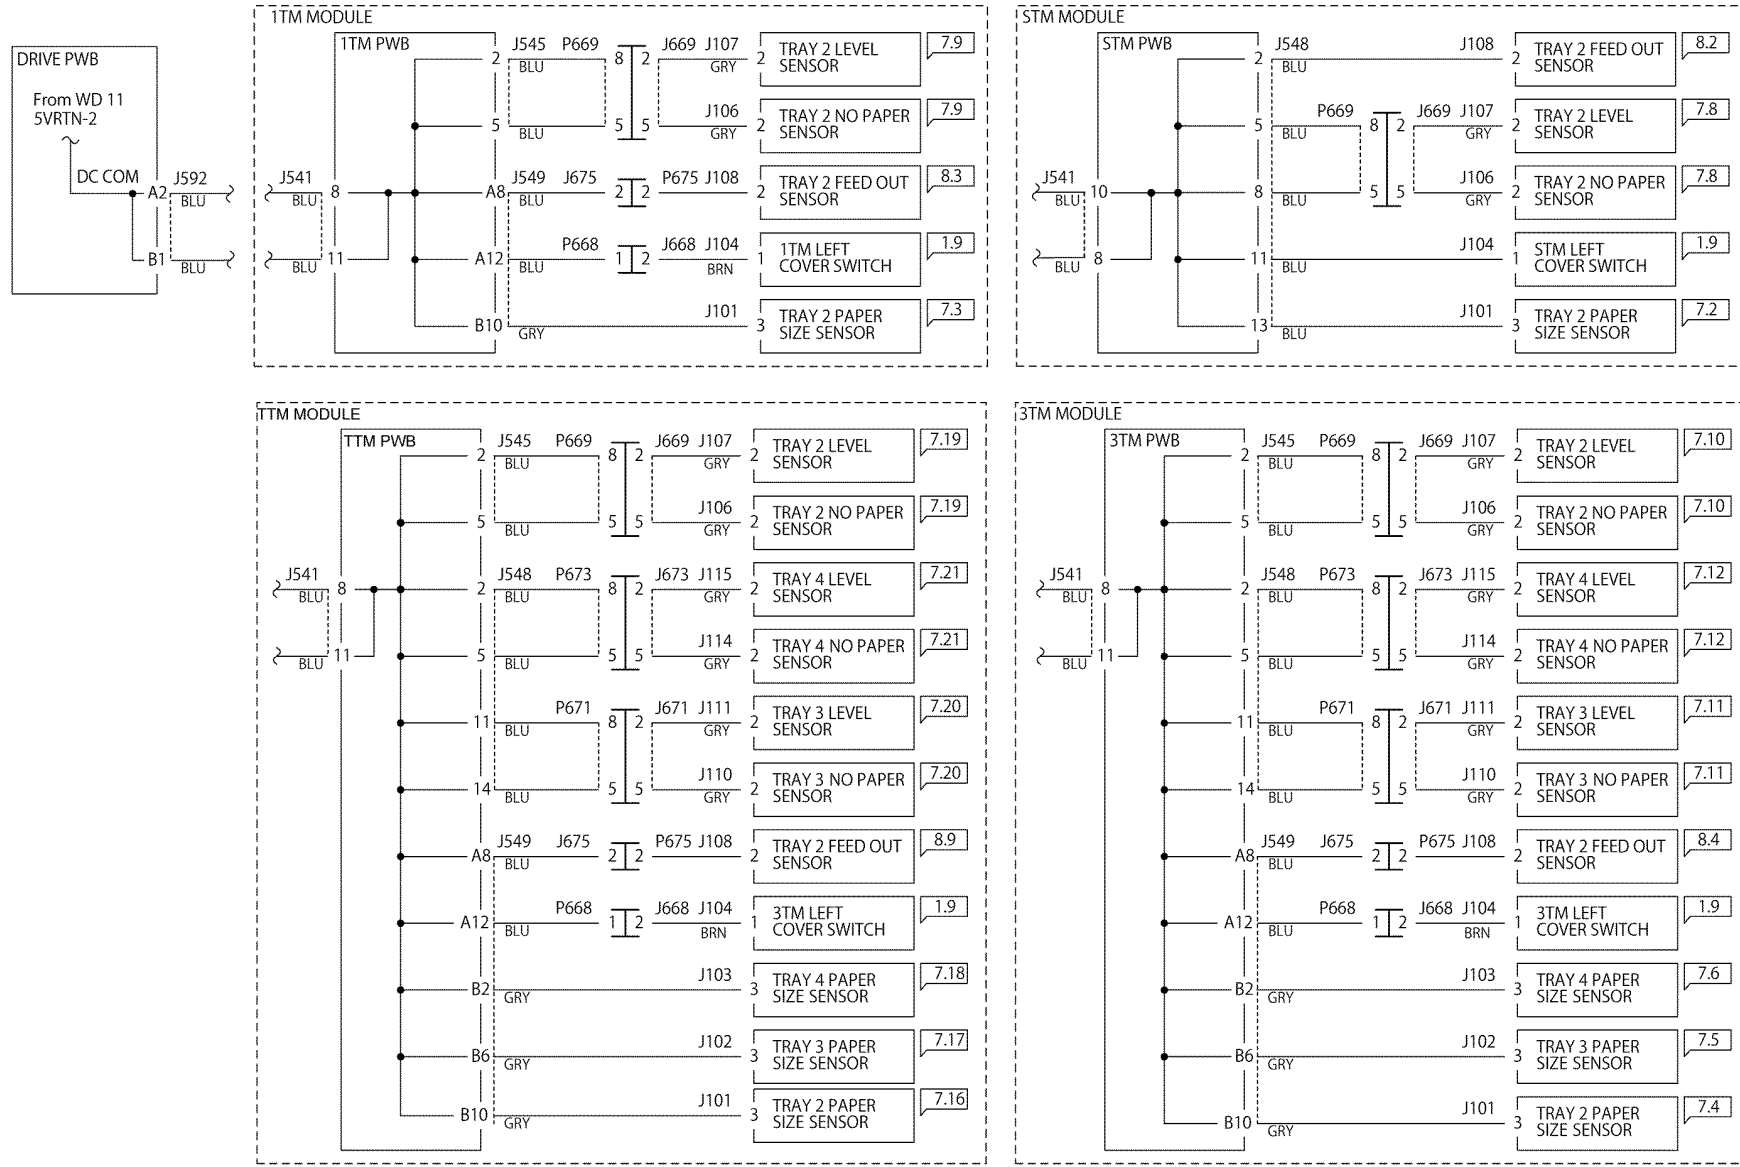
Figure 12 Wiring diagram 12

Wiring Diagram 12 IOT/IIT +5V RTN (3 of 3)

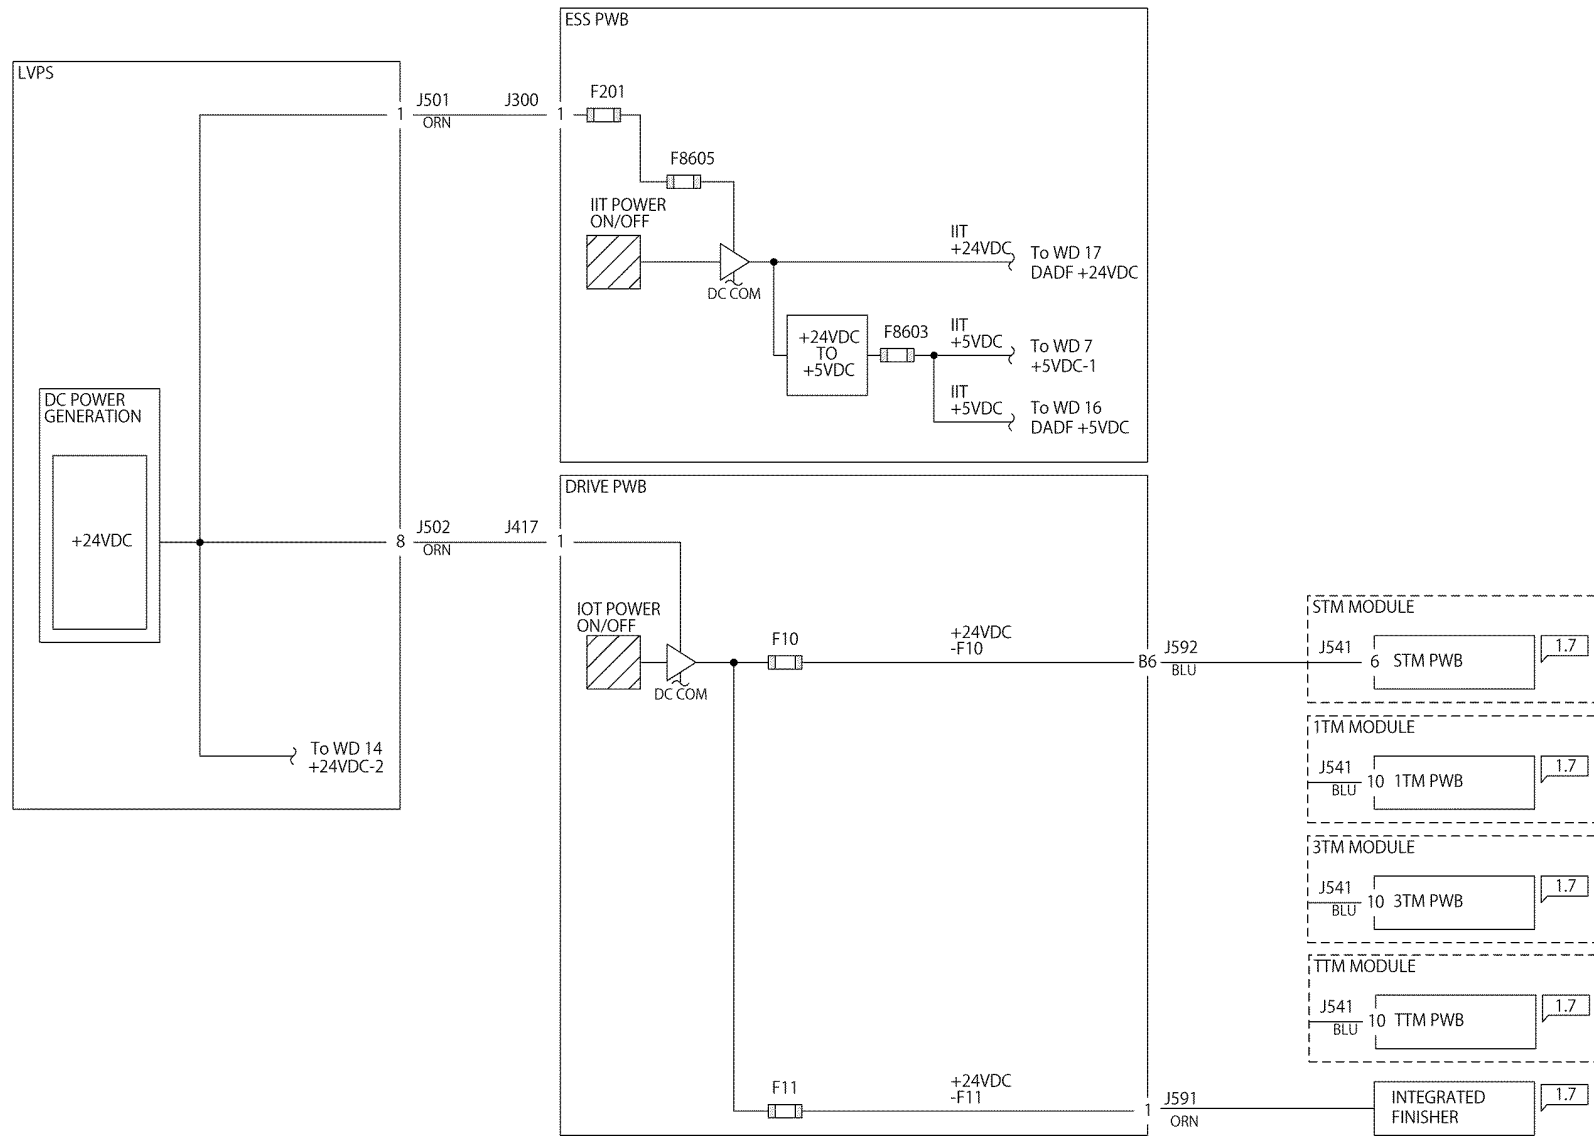
Figure 13 Wiring diagram 13

Wiring Diagram 13 IOT/IIT +24VDC (1 of 2)

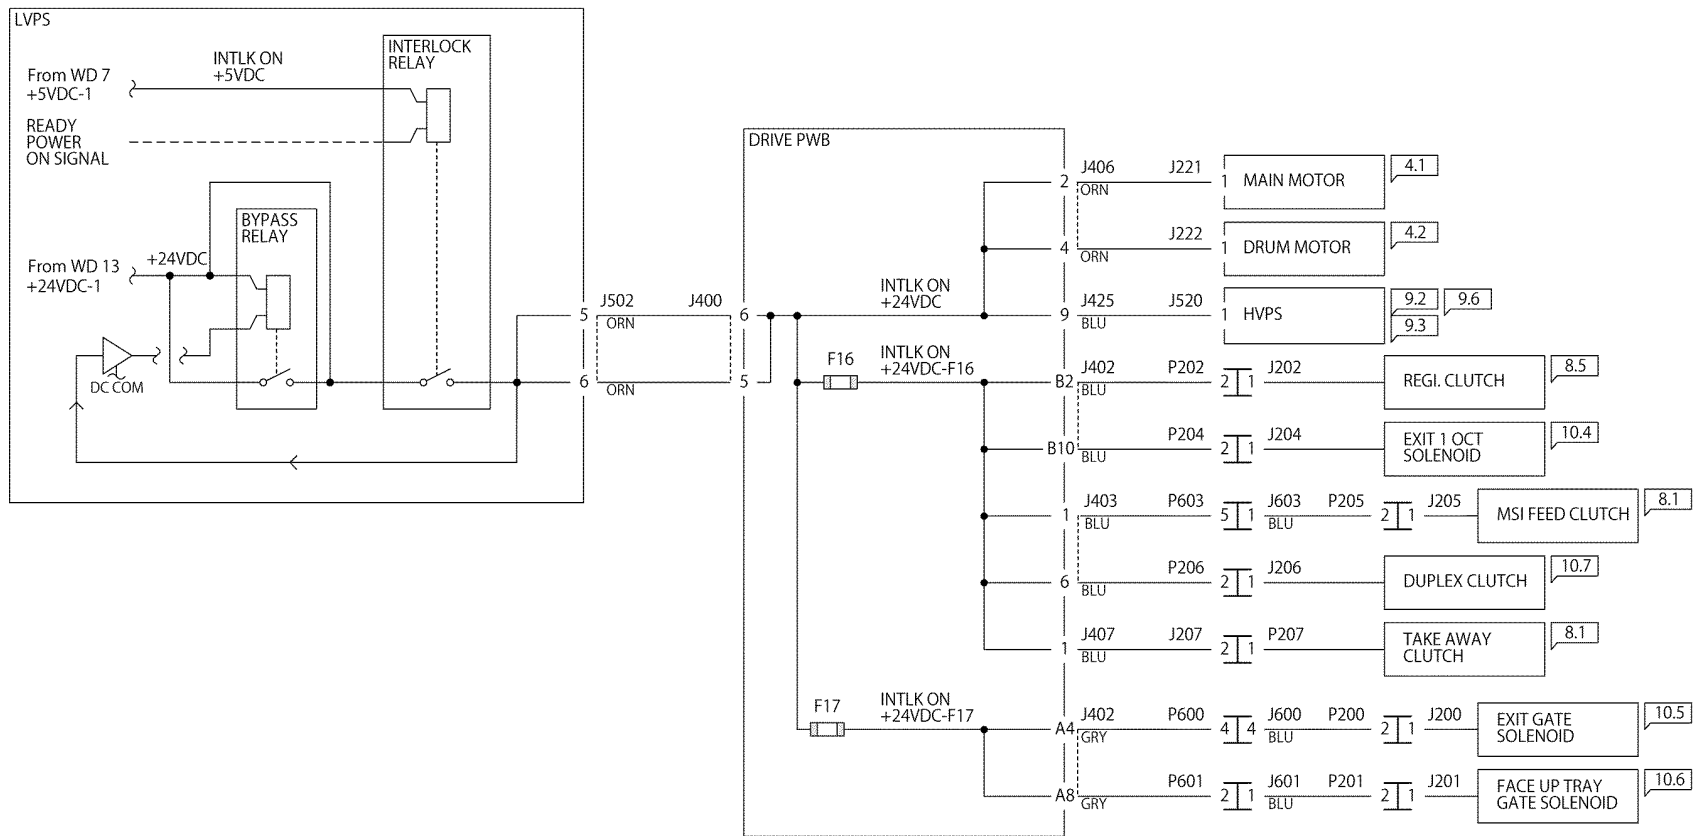
Figure 14 Wiring diagram 14

Wiring Diagram 14 IOT/IIT +24VDC (2 of 2)

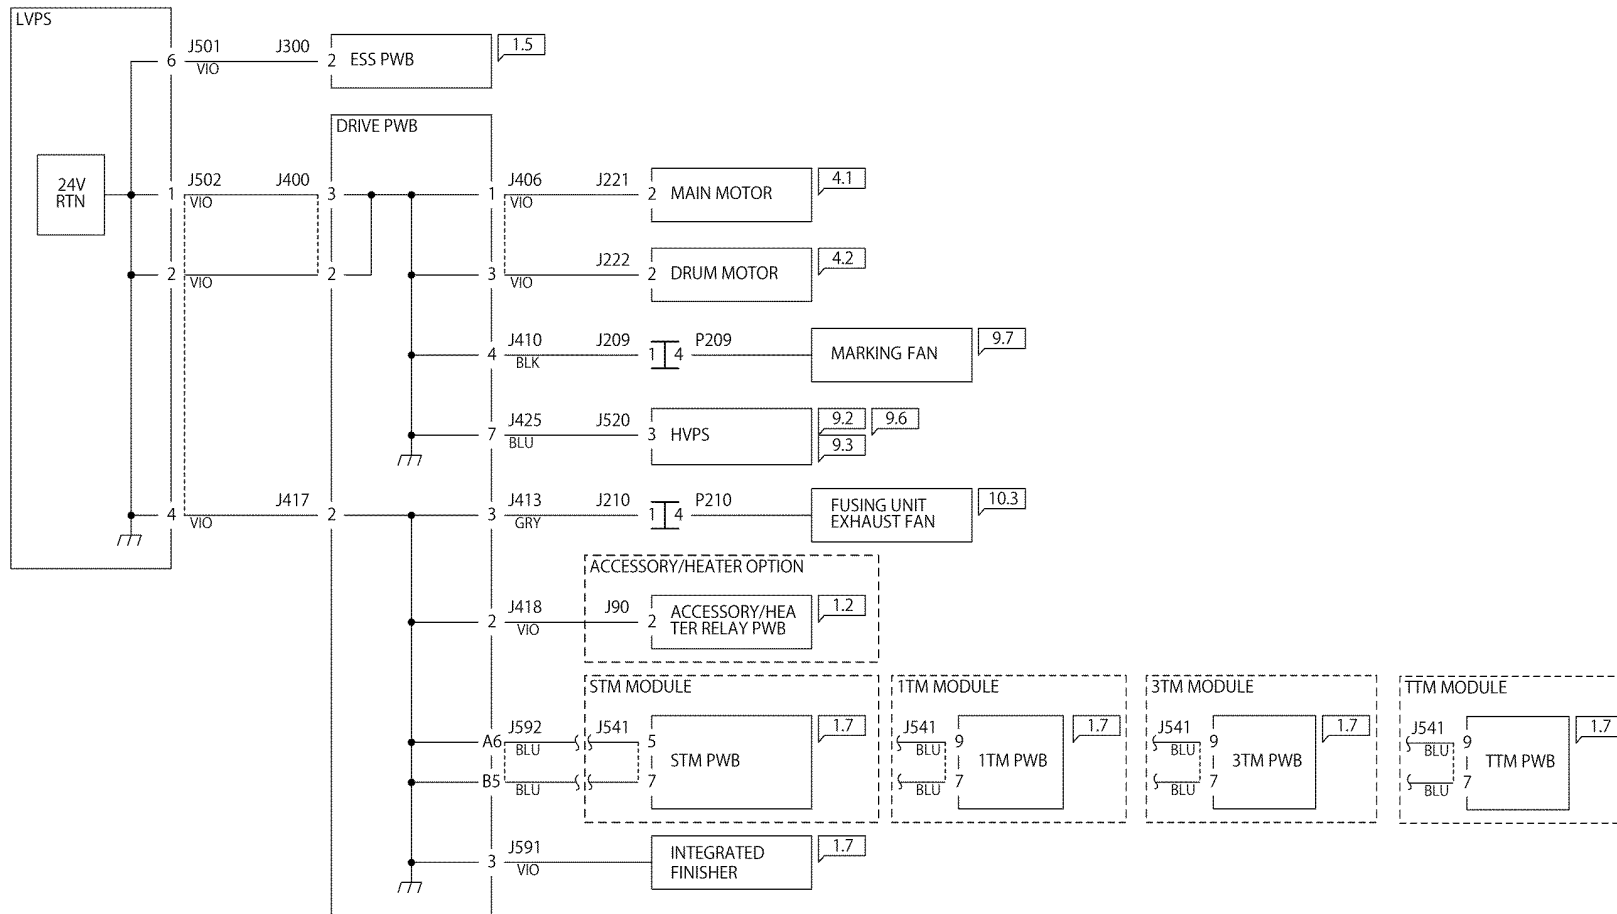
Figure 15 Wiring diagram 15

Wiring Diagram 15 IOT/IIT +24V RTN

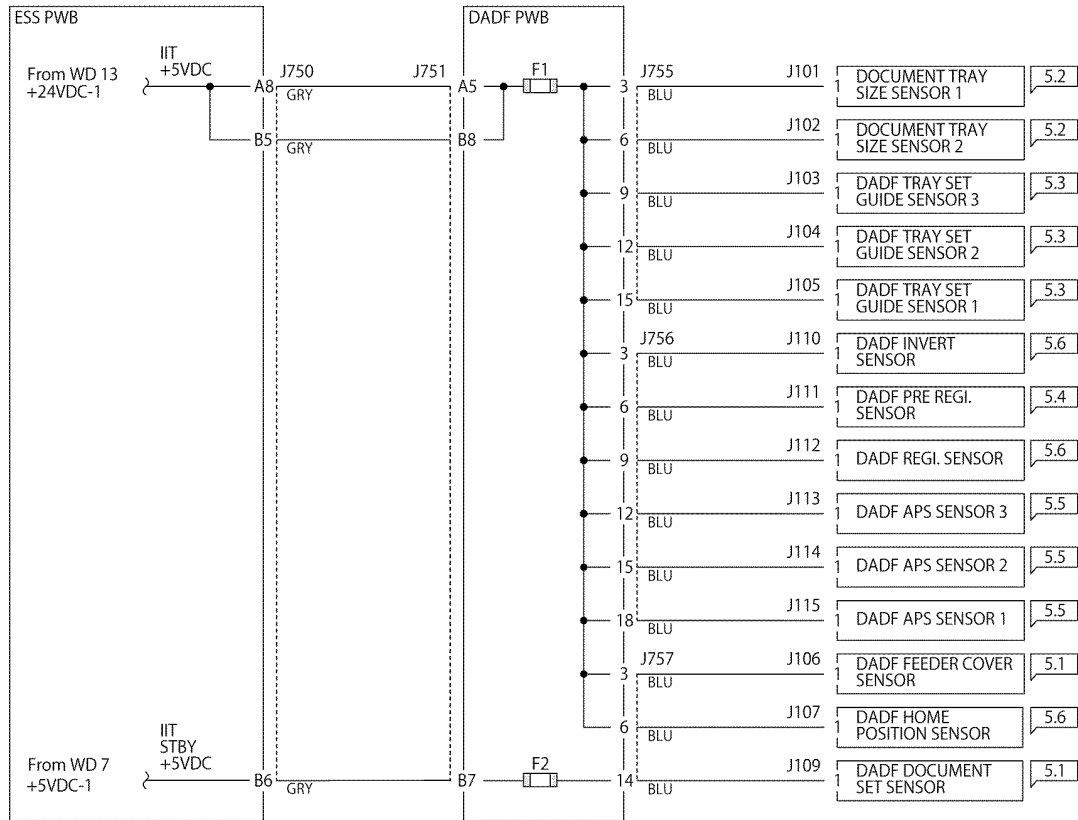
Figure 16 Wiring diagram 16

Wiring Diagram 16 DADF +5VDC

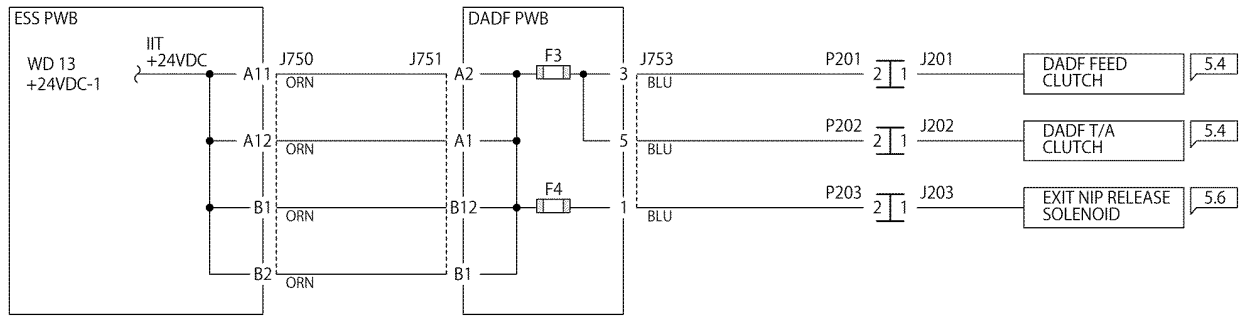
Figure 17 Wiring diagram 17

Wiring Diagram 17 DADF +24VDC

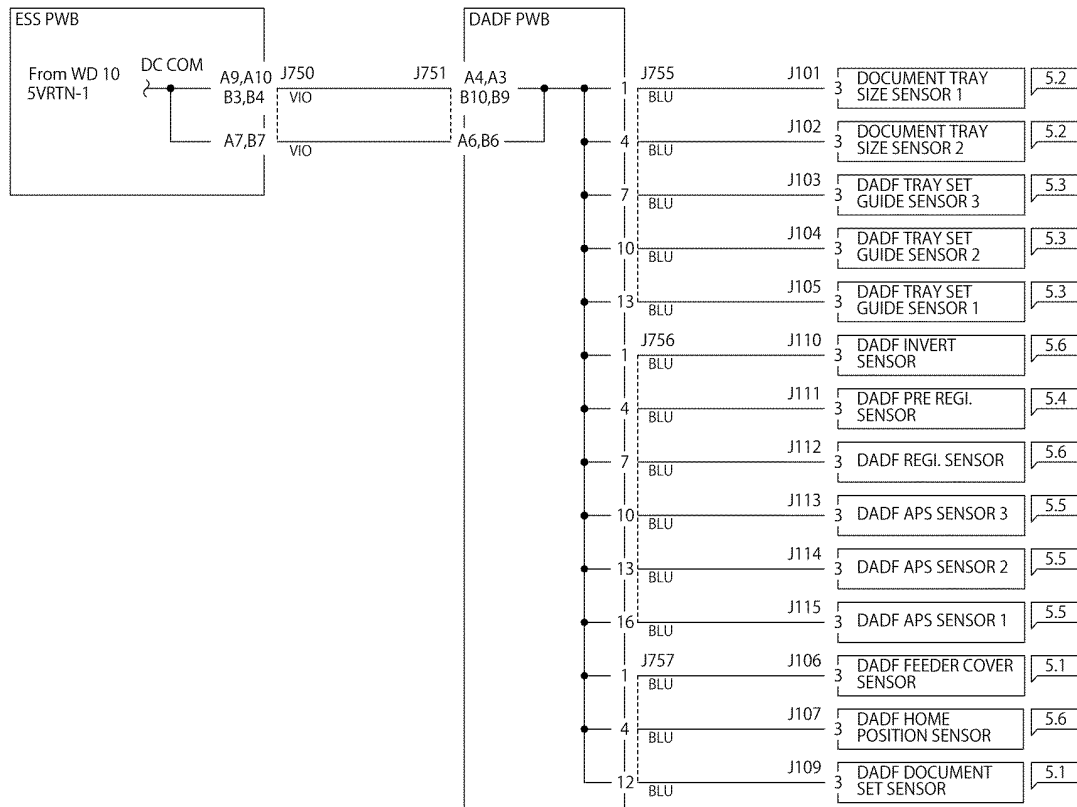
Figure 18 Wiring diagram 18

Wiring Diagram 18 DADF DC COM

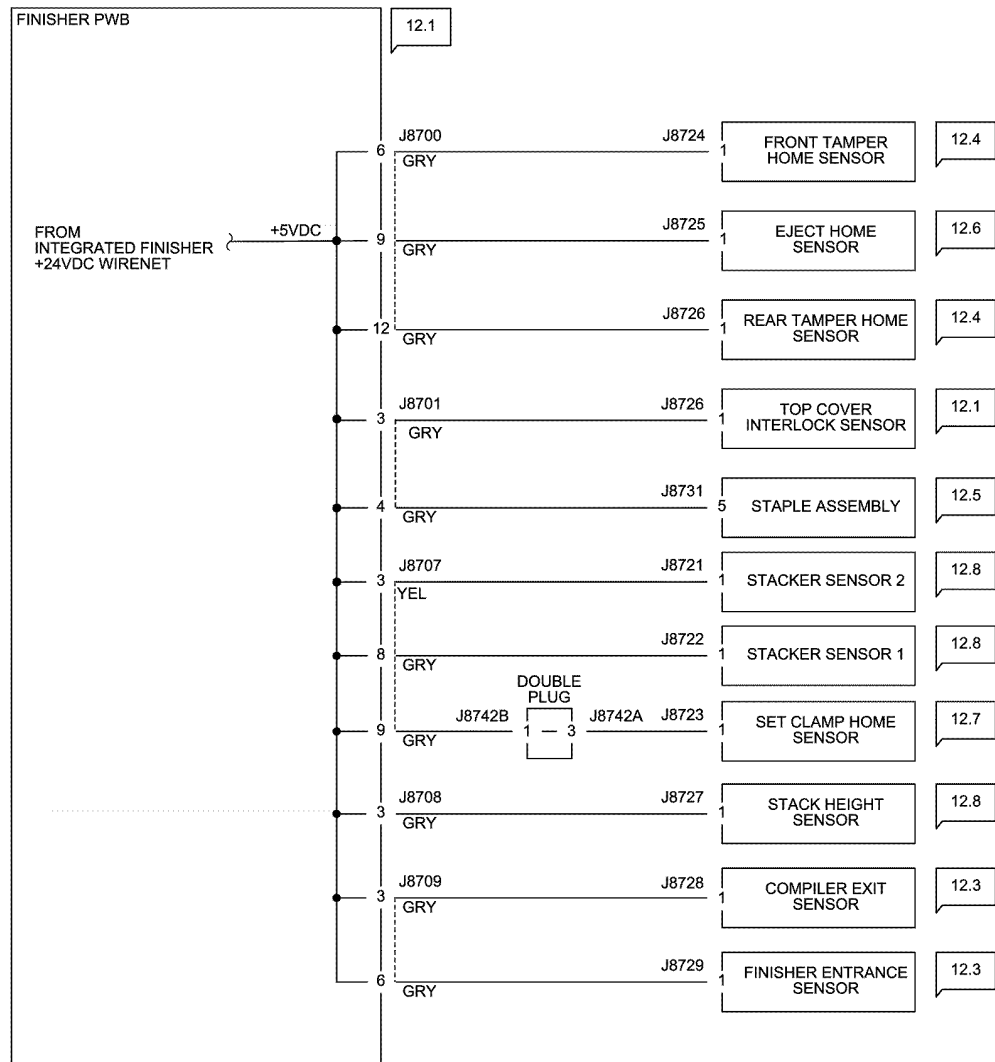
Figure 19 Wiring diagram 19

Wiring Diagram 19 Integrated Office Finisher +5VDC

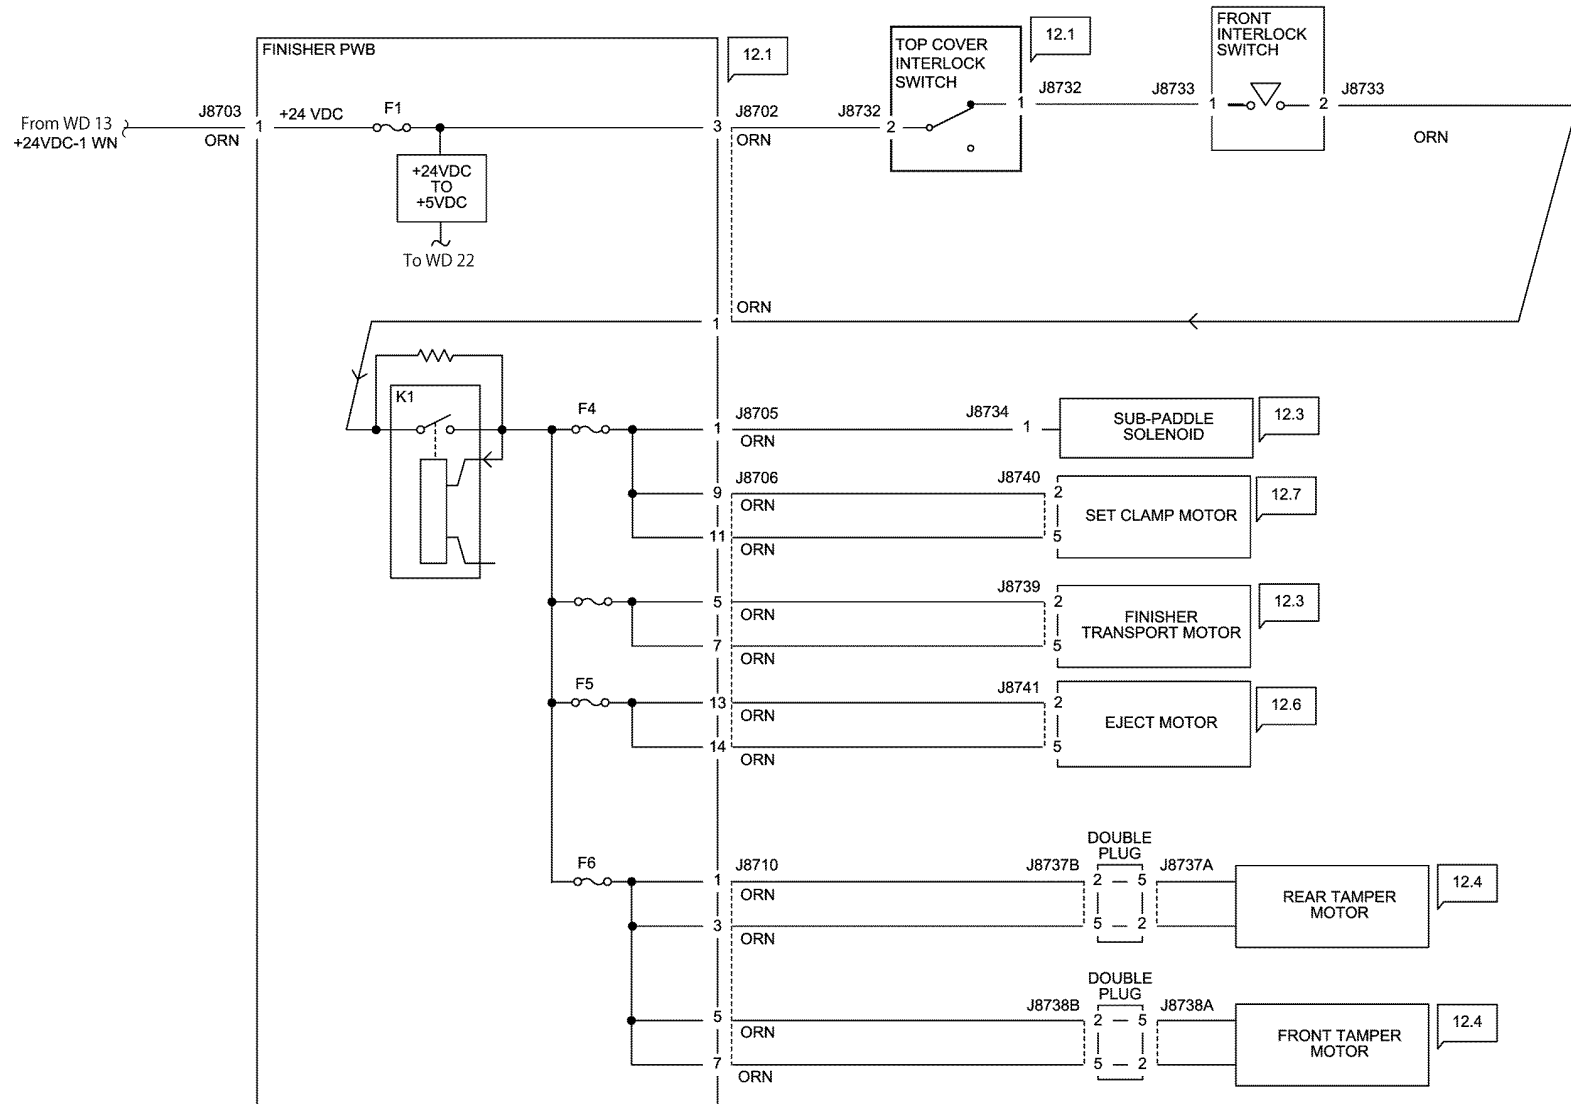
Figure 20 Wiring diagram 20

Wiring Diagram 20 Integrated Office Finisher +24VDC

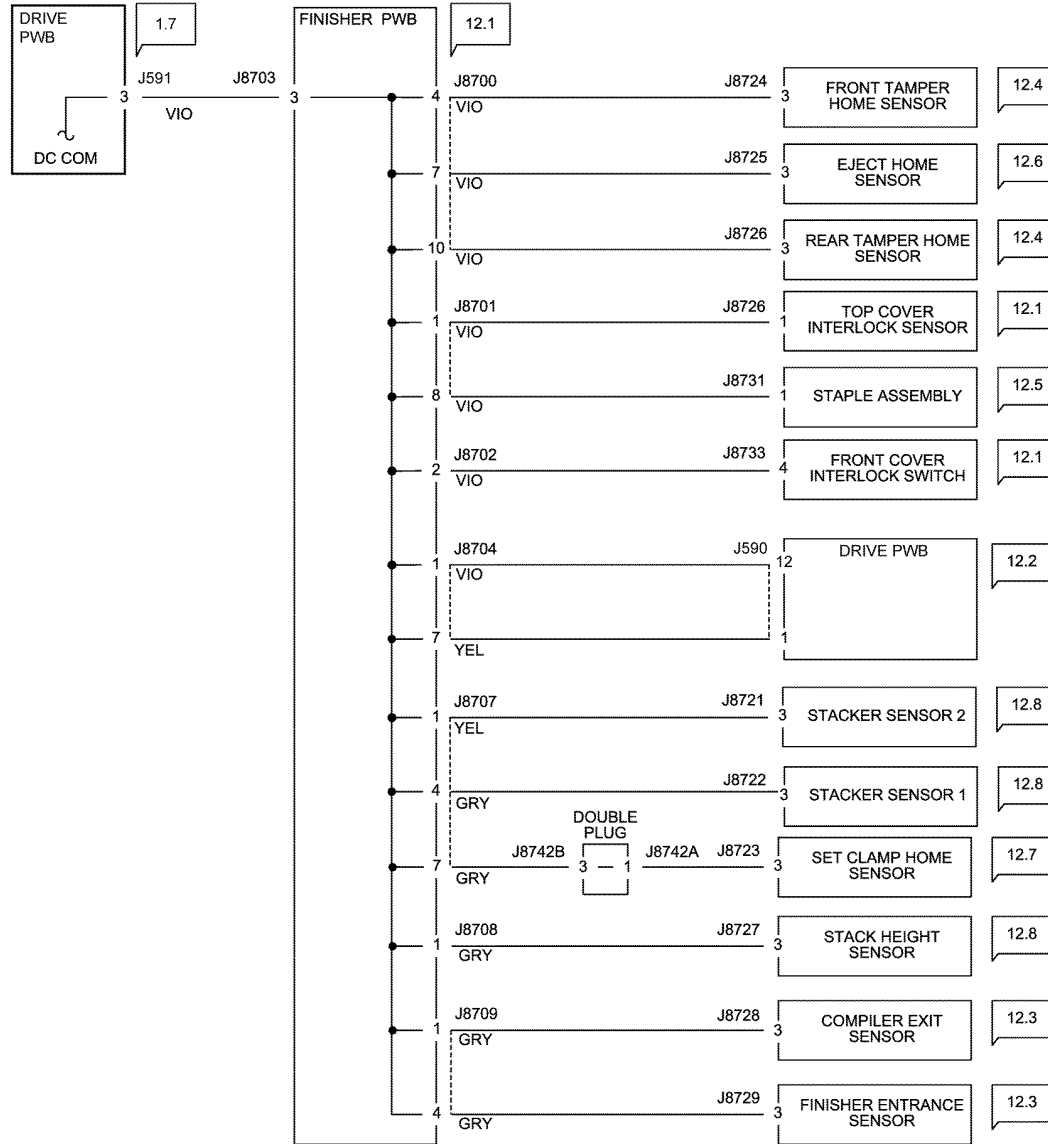
Figure 21 Wiring diagram 21

Wiring Diagram 21 Integrated Office Finisher DC RTN

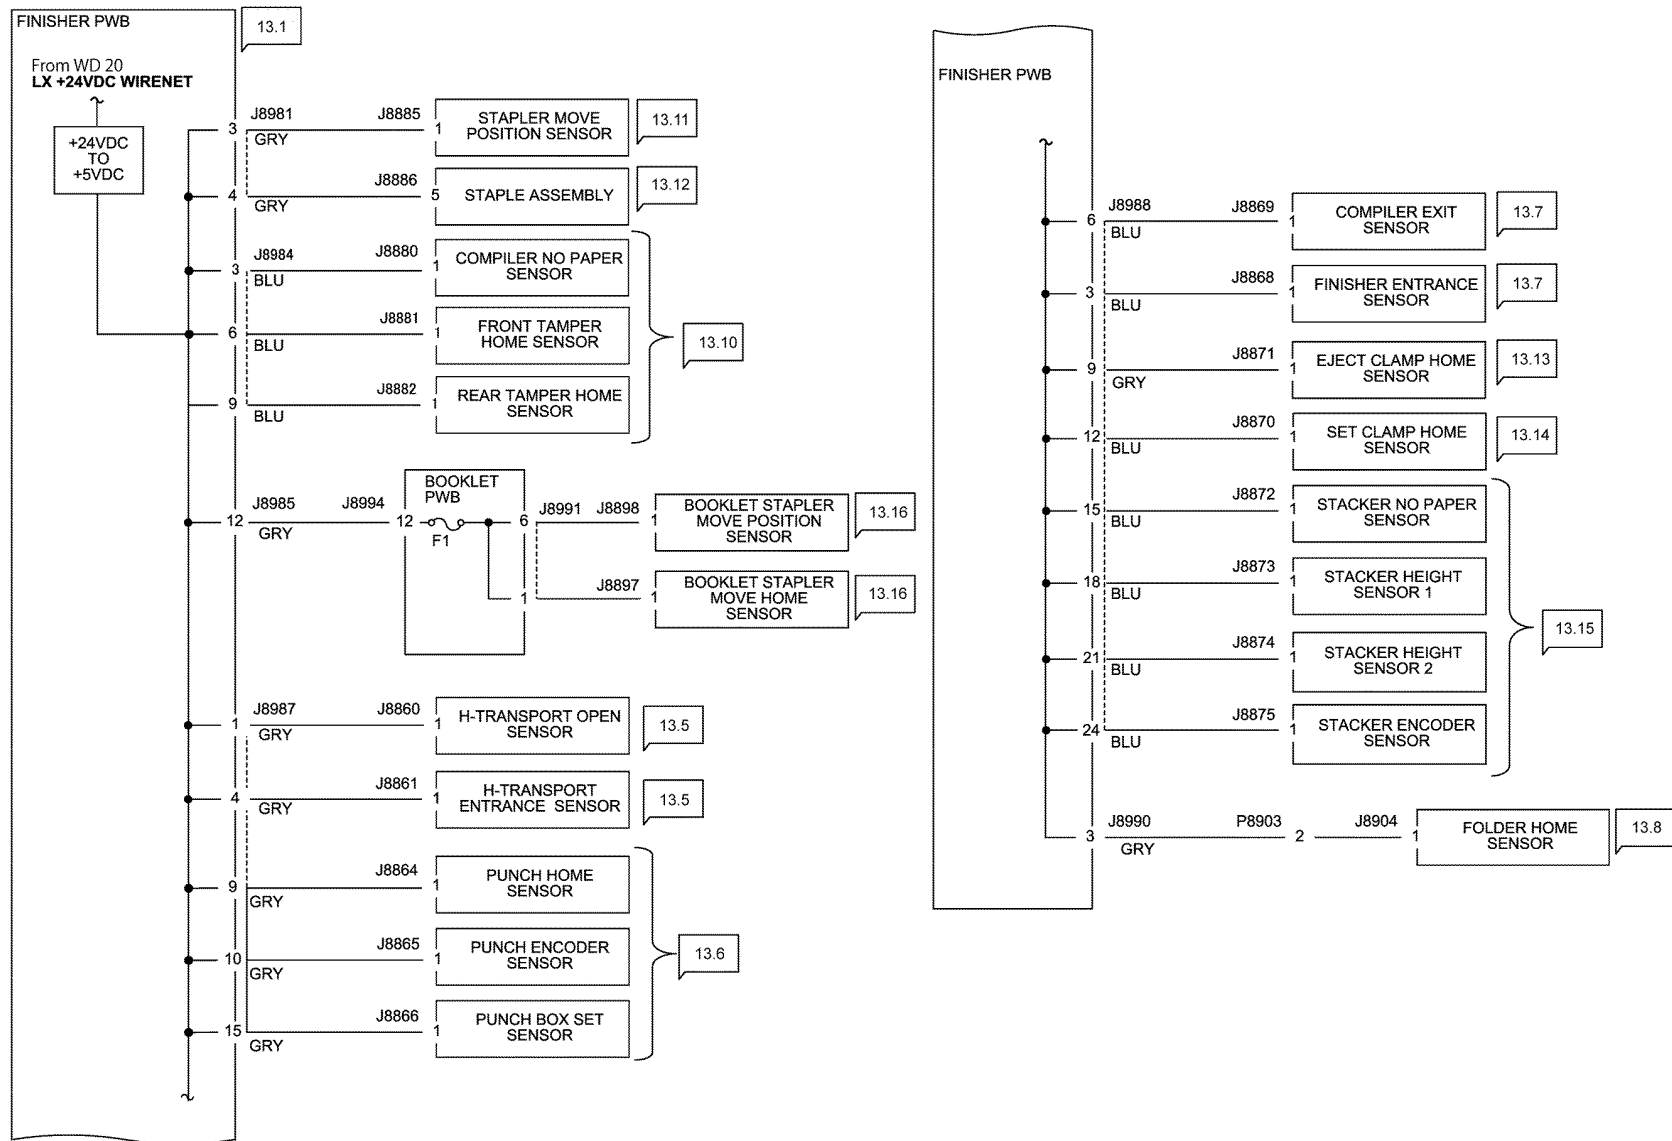
Figure 22 Wiring diagram 22

Wiring Diagram 22 Office Finisher LX +5VDC

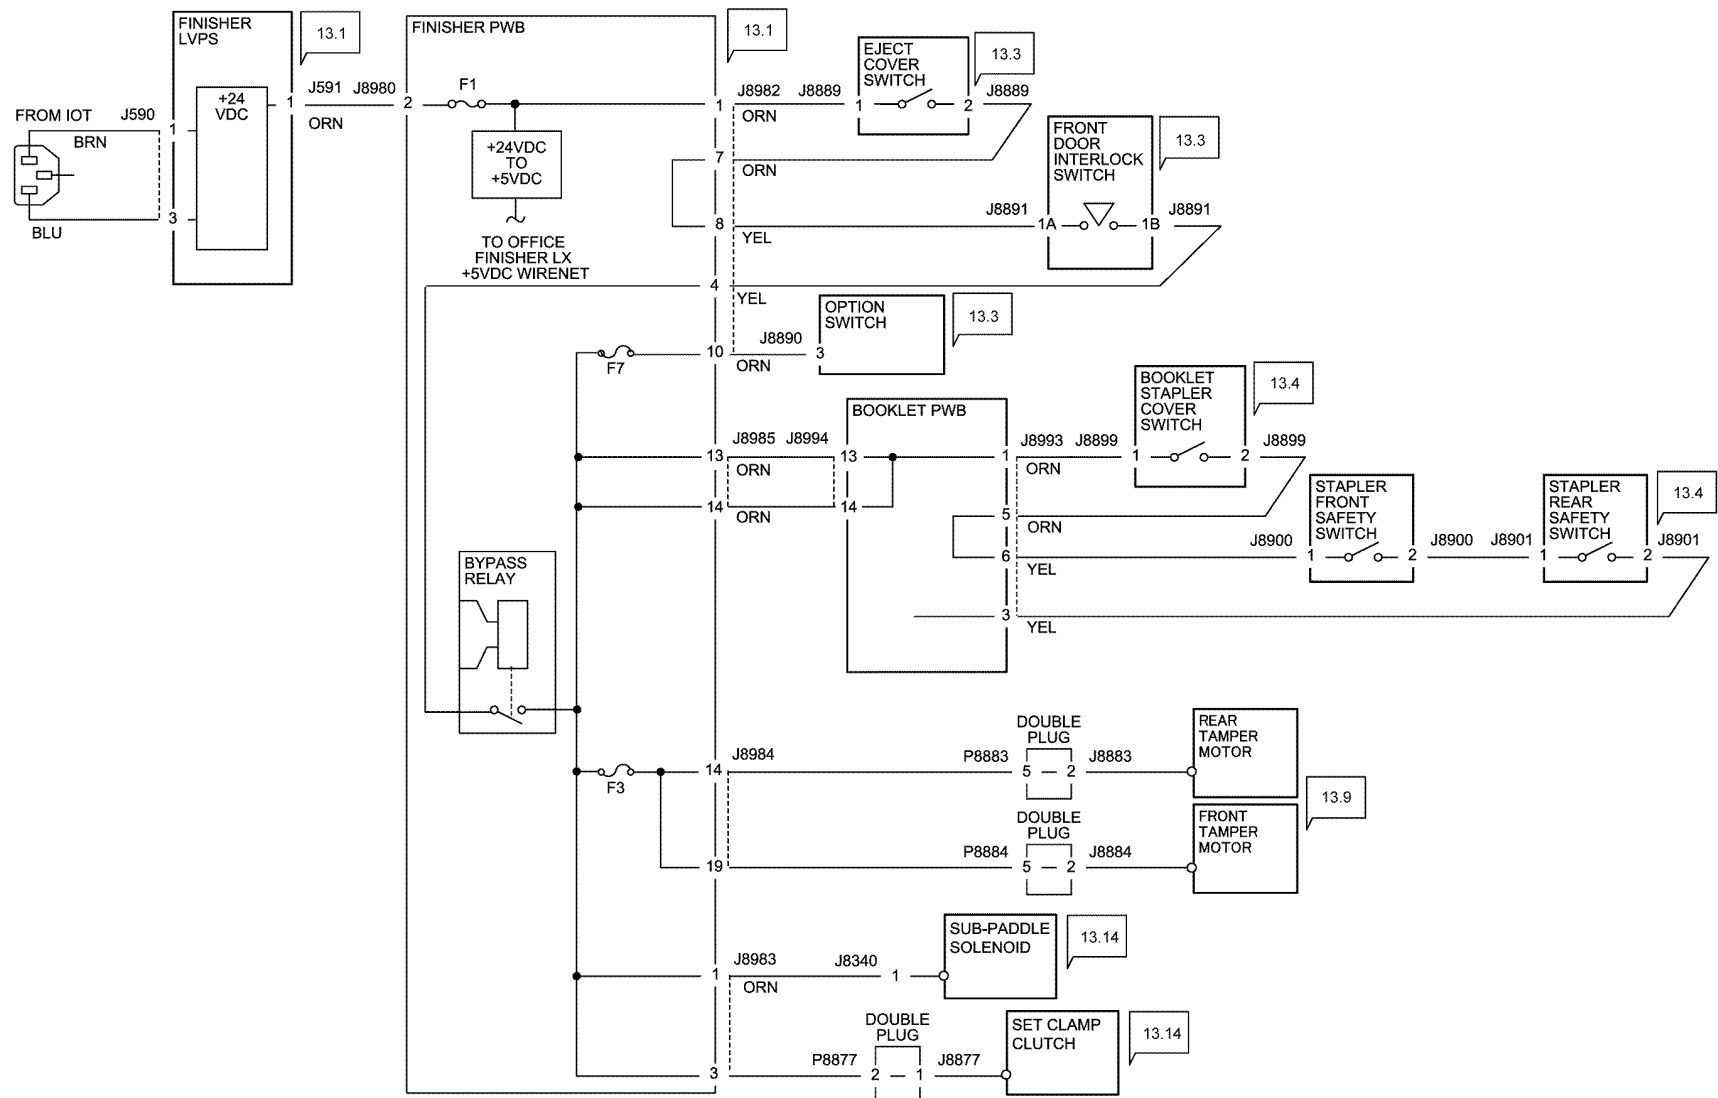
Figure 23 Wiring diagram 23

Wiring Diagram 23 Office Finisher LX +24VDC

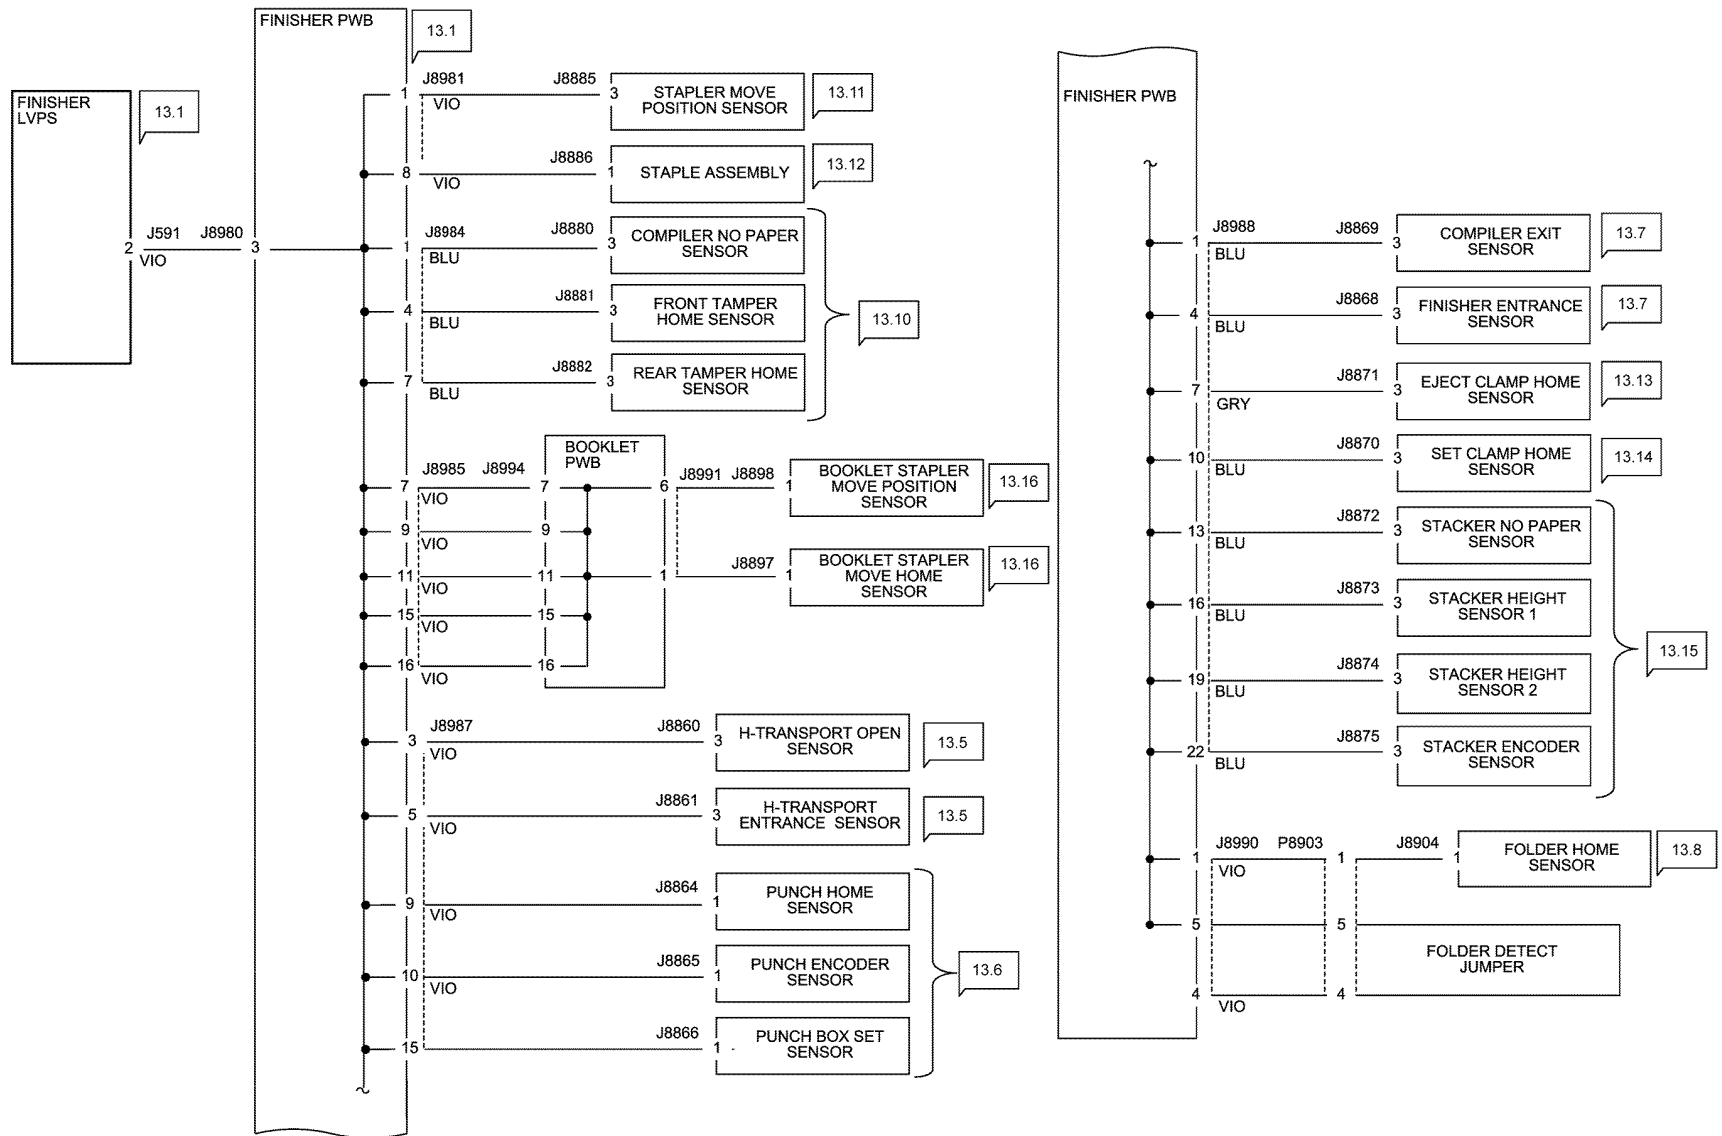
Figure 24 Wiring diagram 24

Wiring Diagram 24 Office Finisher LX DC RTN

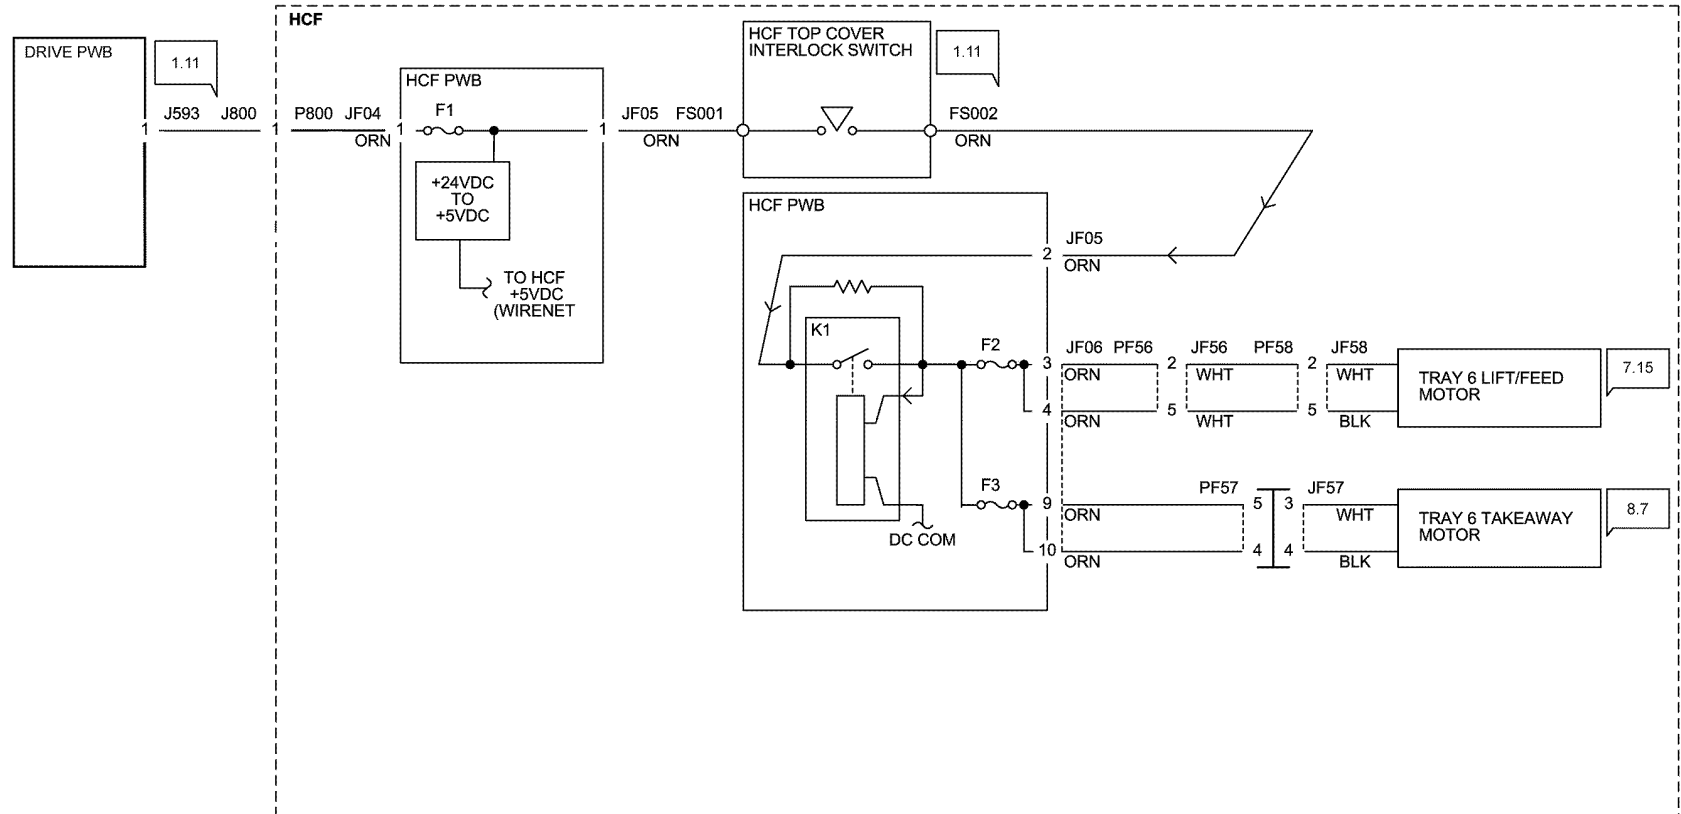
Figure 25 Wiring diagram 25

Wiring Diagram 25 HCF +24VDC

WD 25 HCF (1 OF 3)

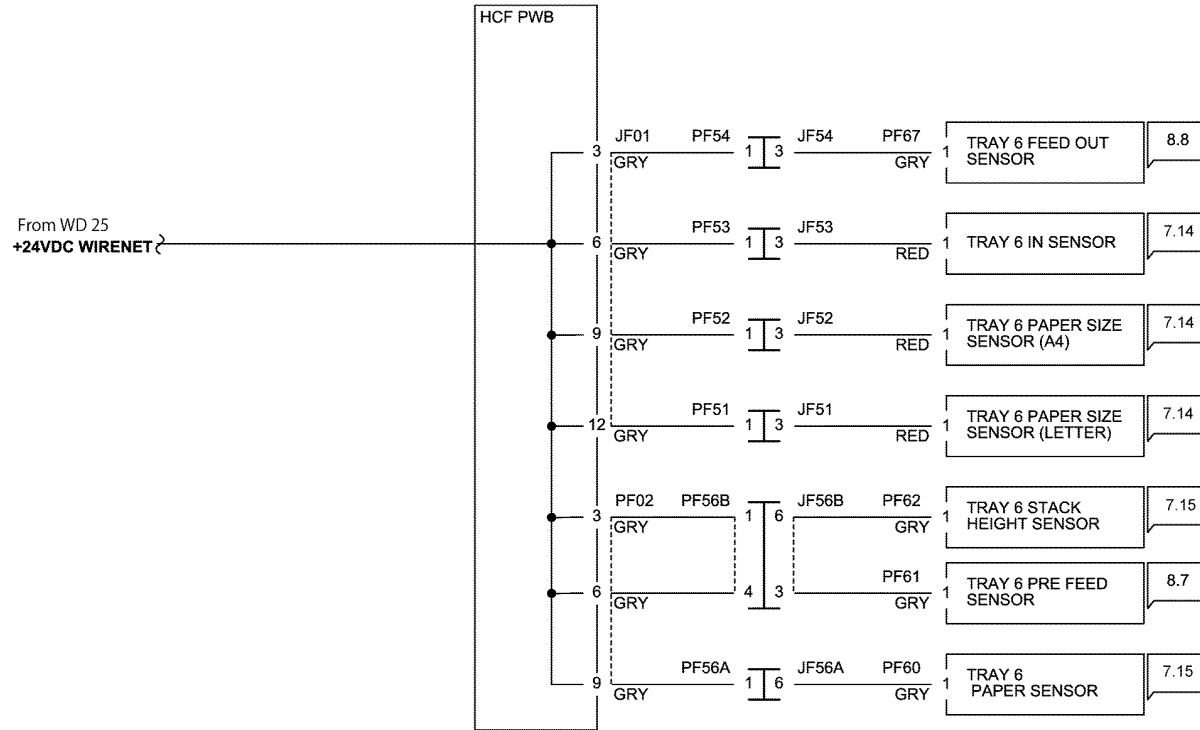
Figure 26 Wiring diagram 26

Wiring Diagram 26 HCF +5VDC

WD 26 HCF (2 OF 3)

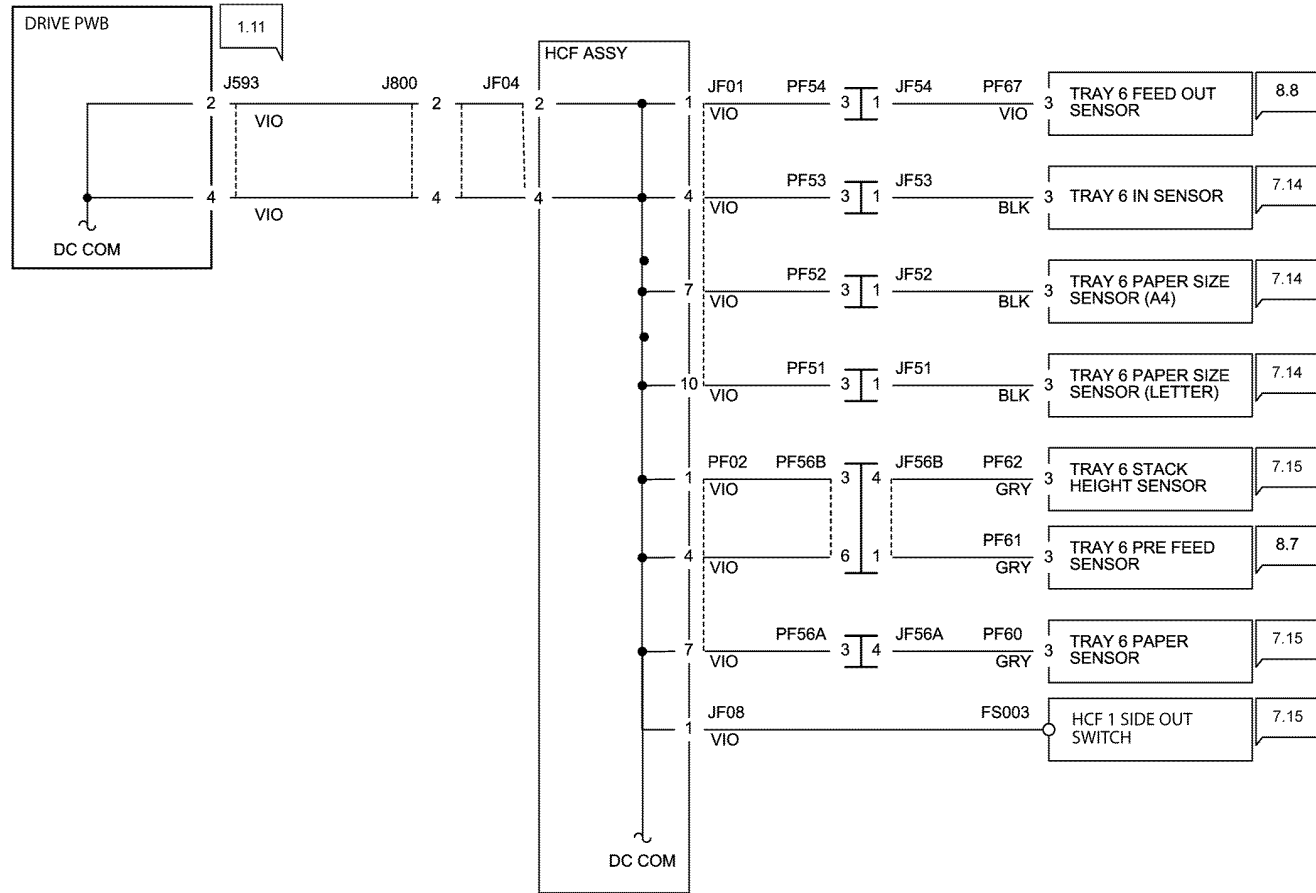
Figure 27 Wiring diagram 27

Wiring Diagram 27 HCF DC COM

WD 27 HCF (3 OF 3)

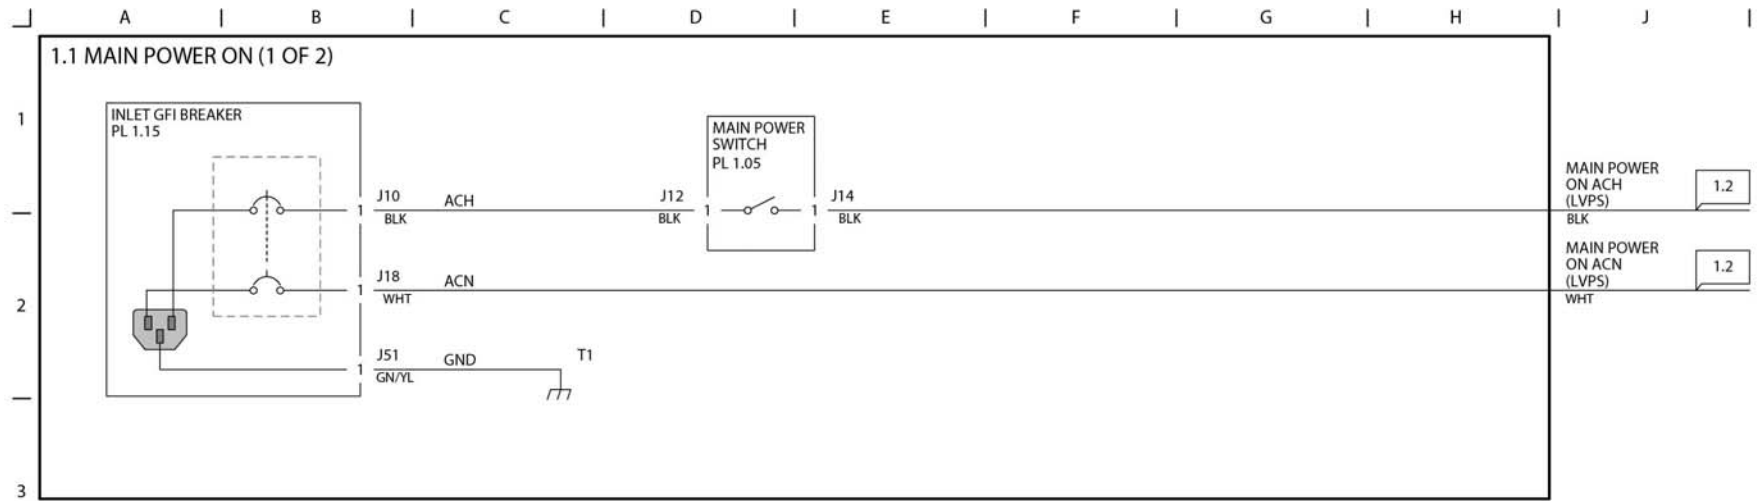
Figure 2 BSD 1.1

BSD 1.1 Main Power On (1 of 2)
