708P91370
April 2017

Xerox® VersaLink® B7025/B7030/B7035 Multifunction Printer Service Manual

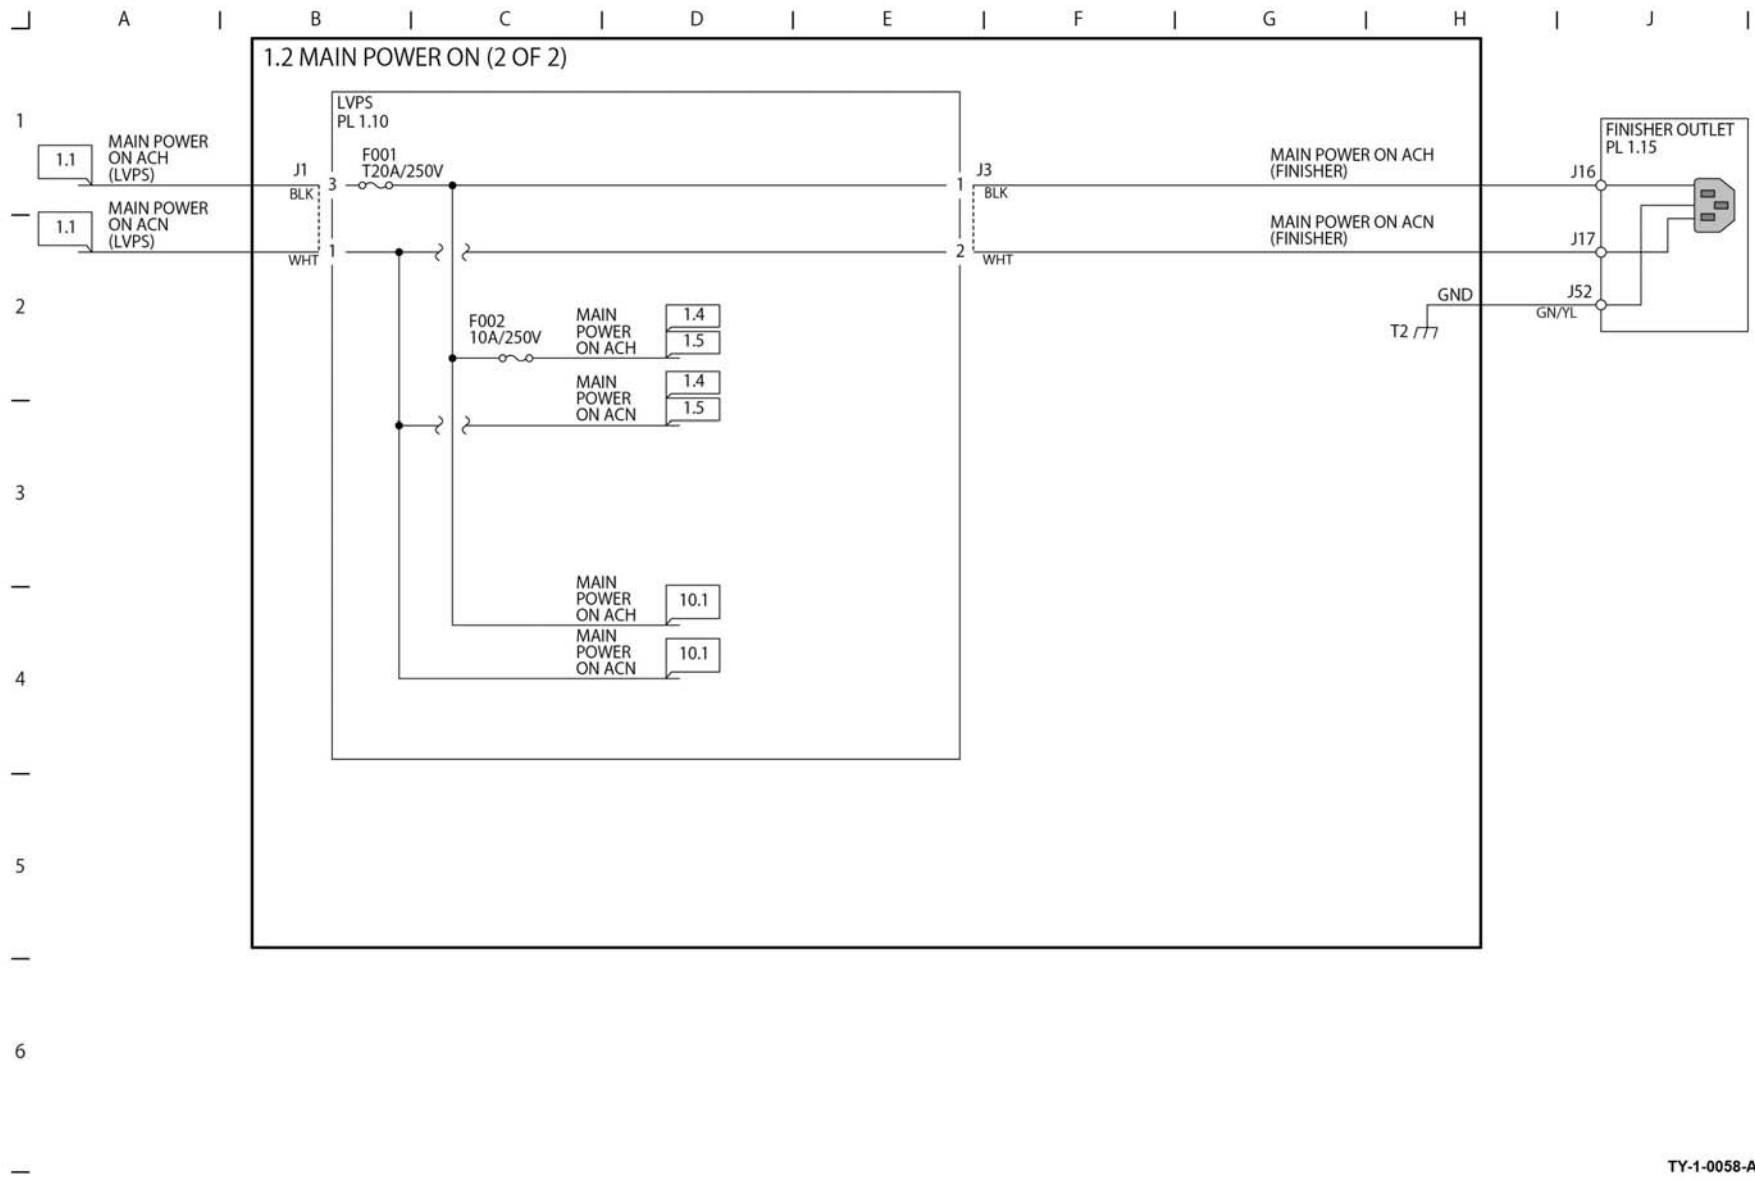
Figure 3 BSD 1.2

BSD 1.2 Main Power On (2 of 2)

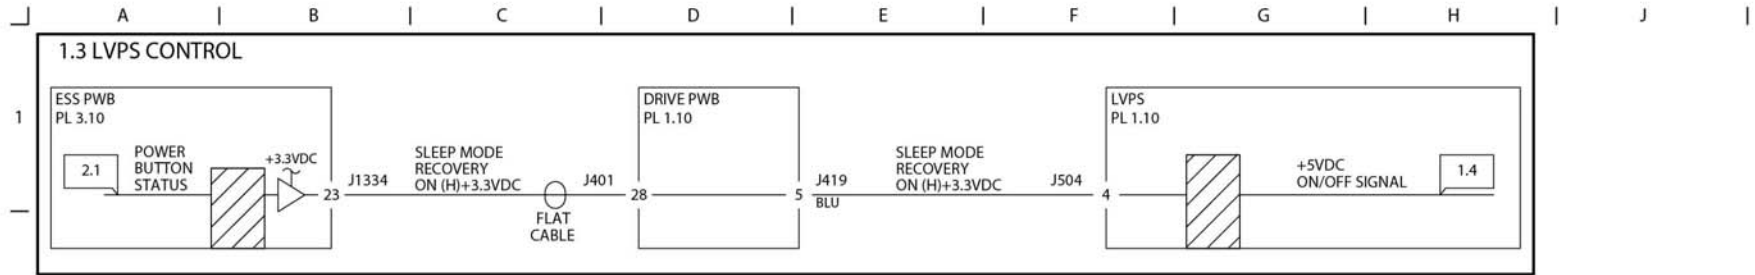
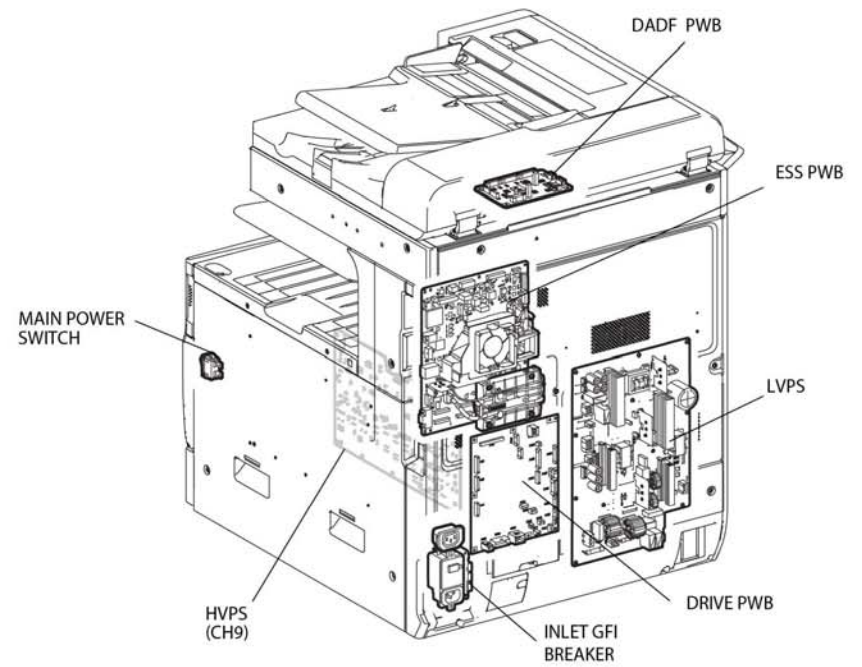
Figure 4 BSD 1.3

BSD 1.3 LVPS Control

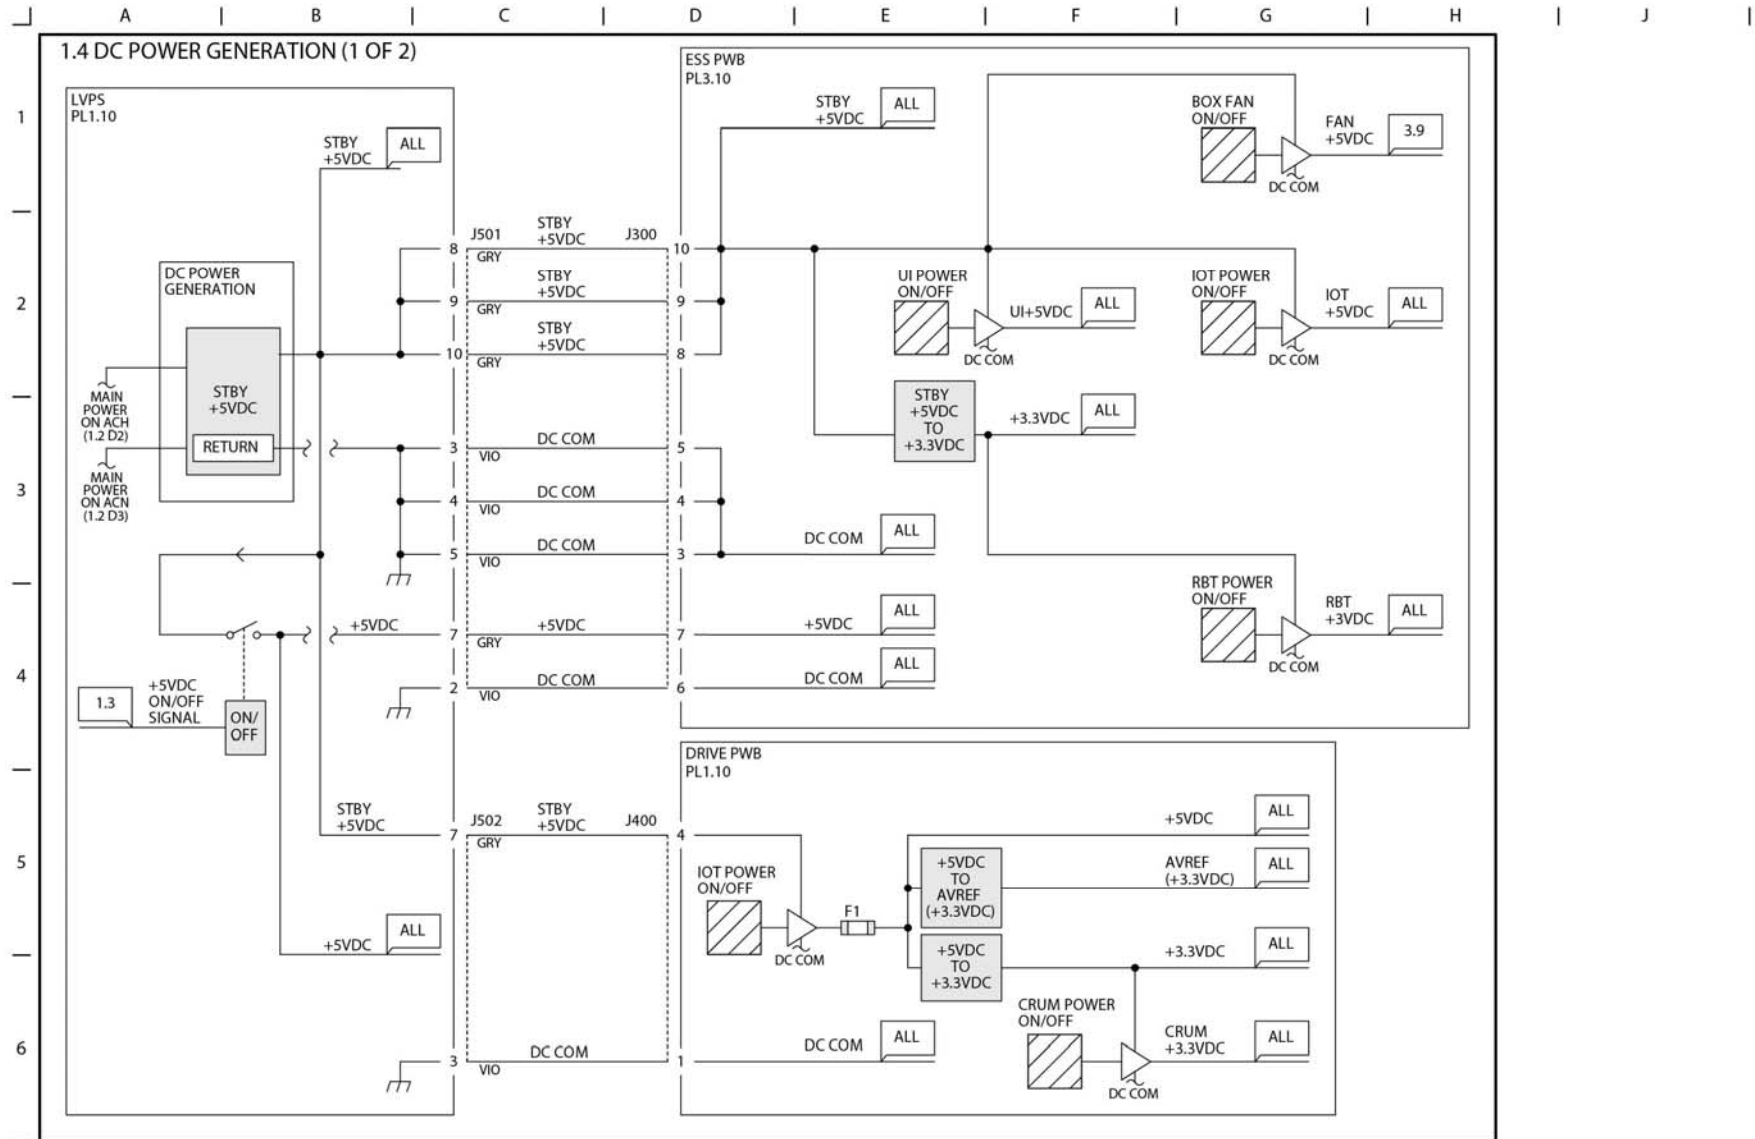
Figure 5 BSD 1.4

BSD 1.4 DC Power Generation (1 of 2)

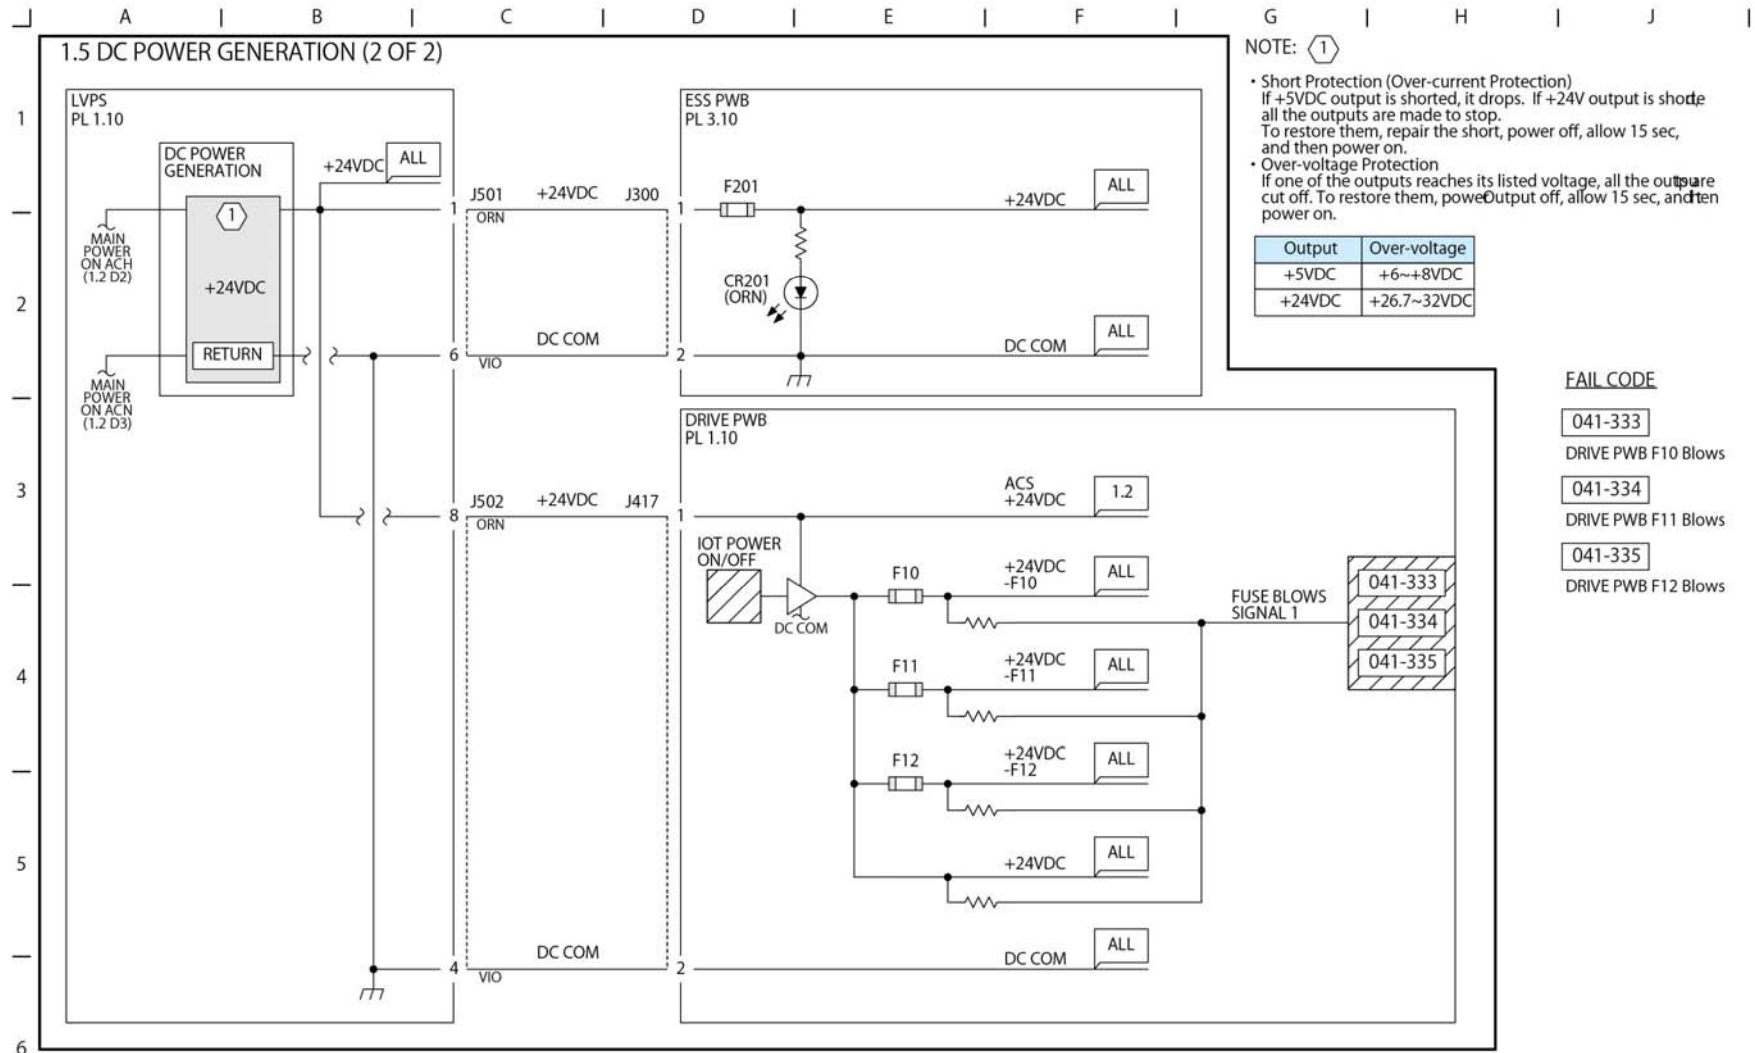
Figure 6 BSD 1.5

BSD 1.5 DC Power Generation (2 of 2)

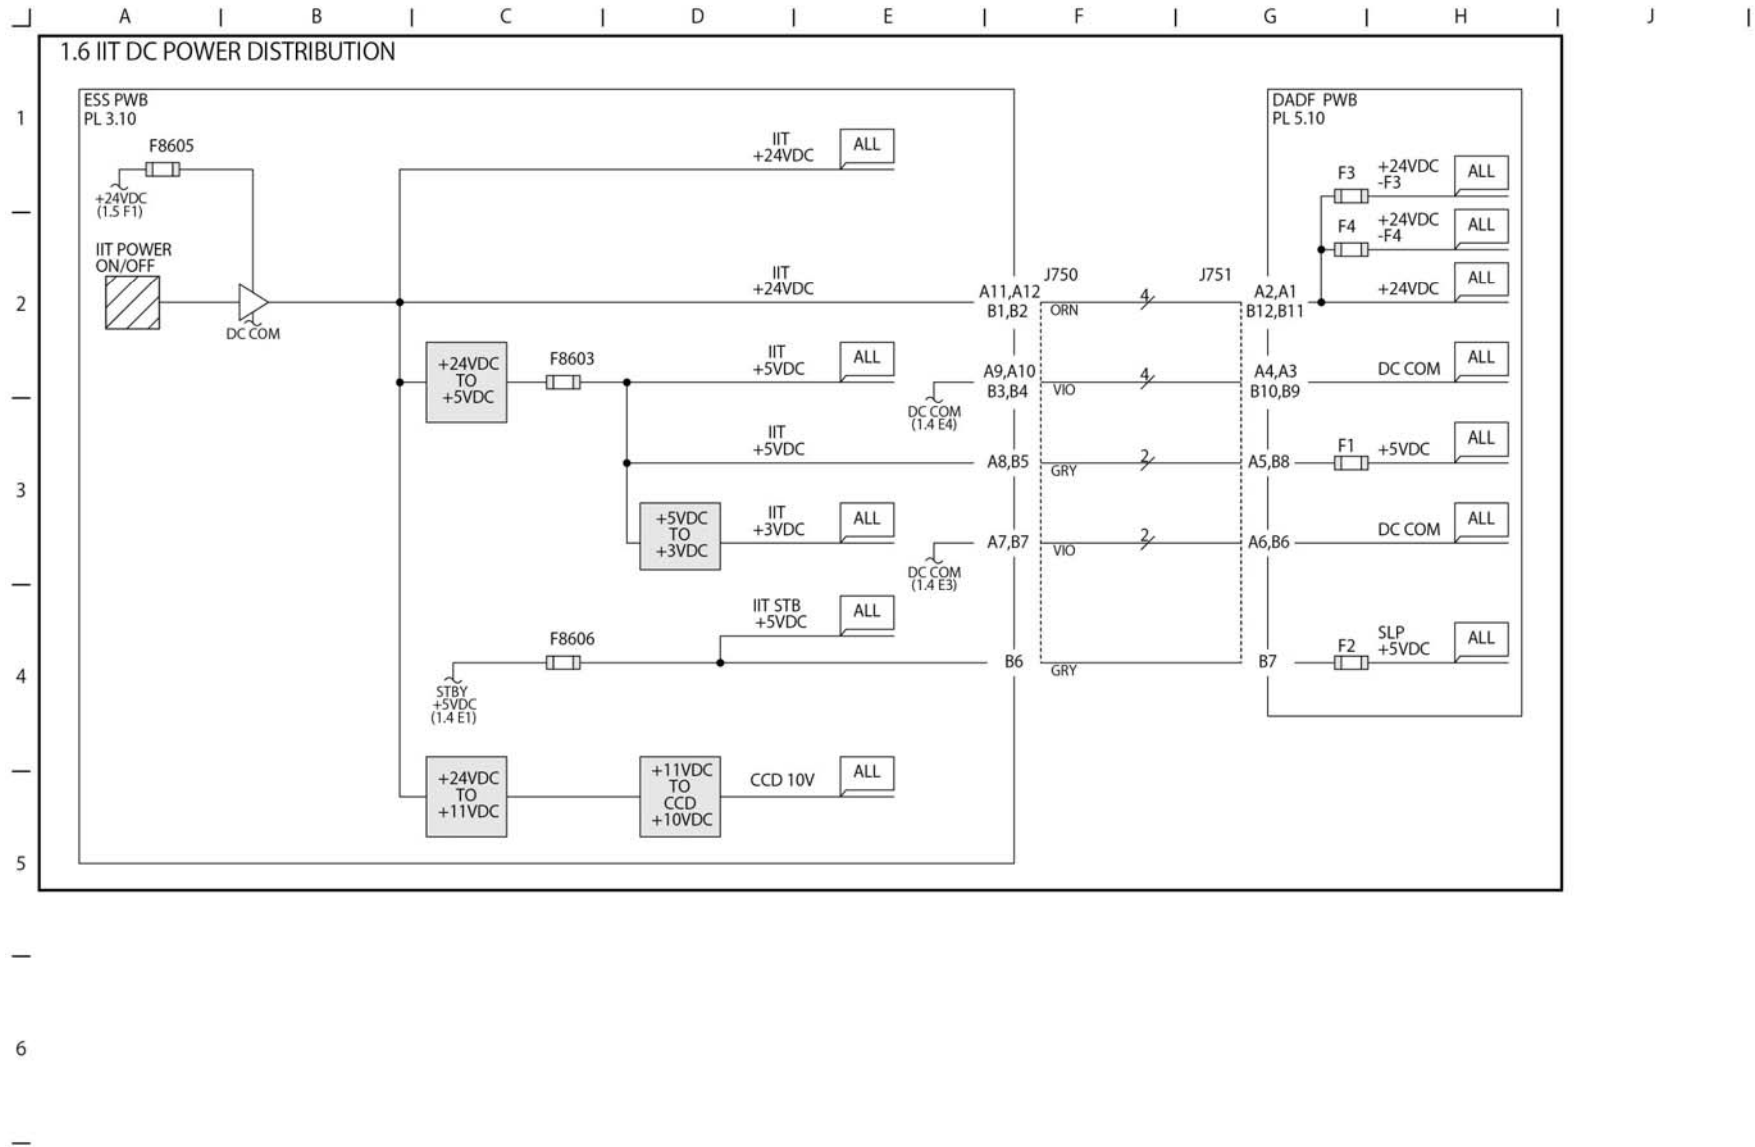
Figure 7 BSD 1.6

BSD 1.6 IIT DC Power Distribution

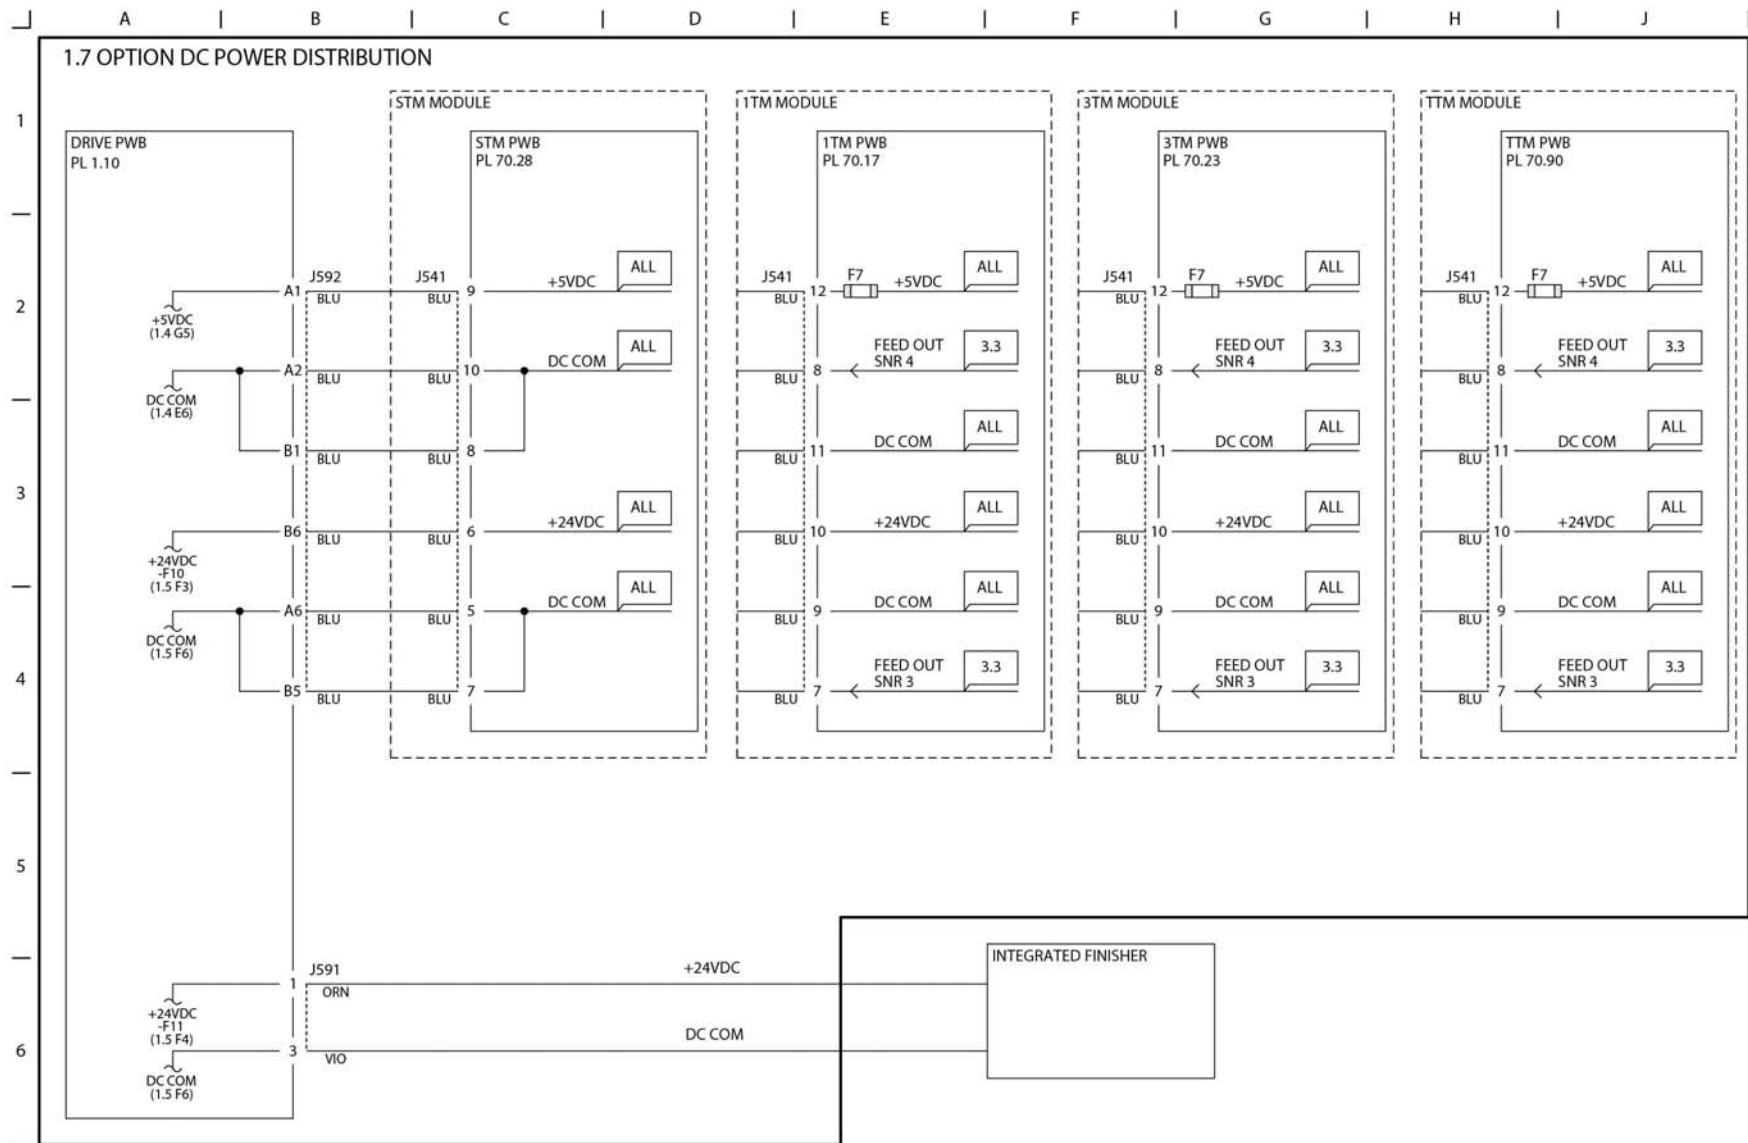
Figure 8 BSD 1.7

BSD 1.7 Option DC Power Distribution

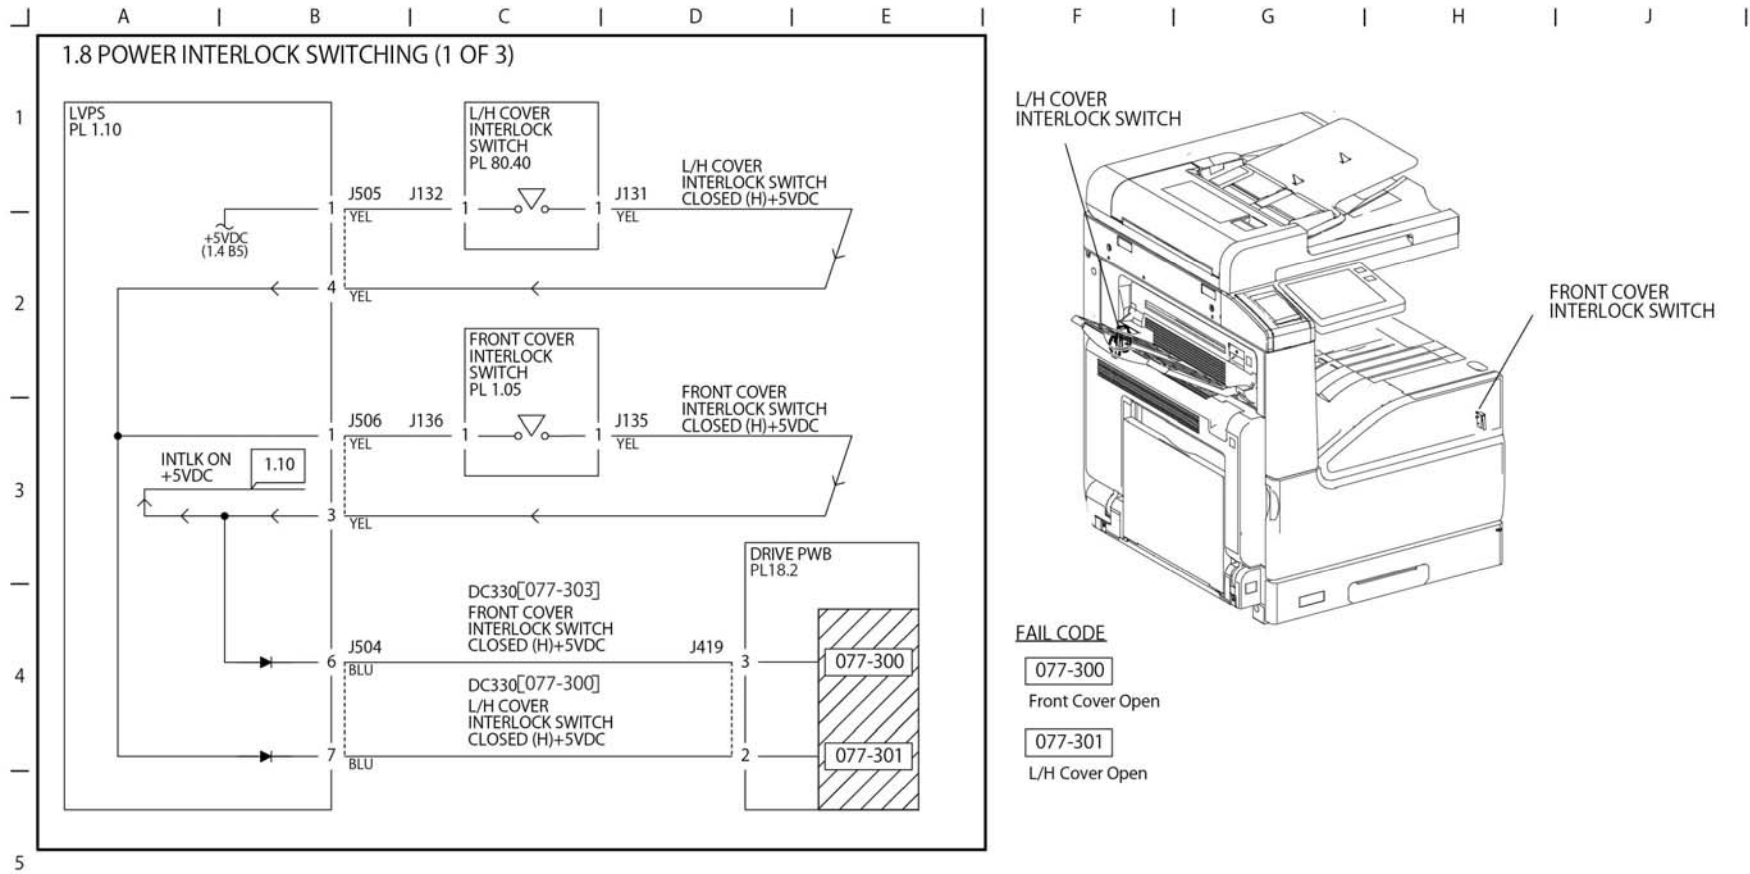
Figure 9 BSD 1.8

BSD 1.8 Power Interlock Switching (1 of 3)

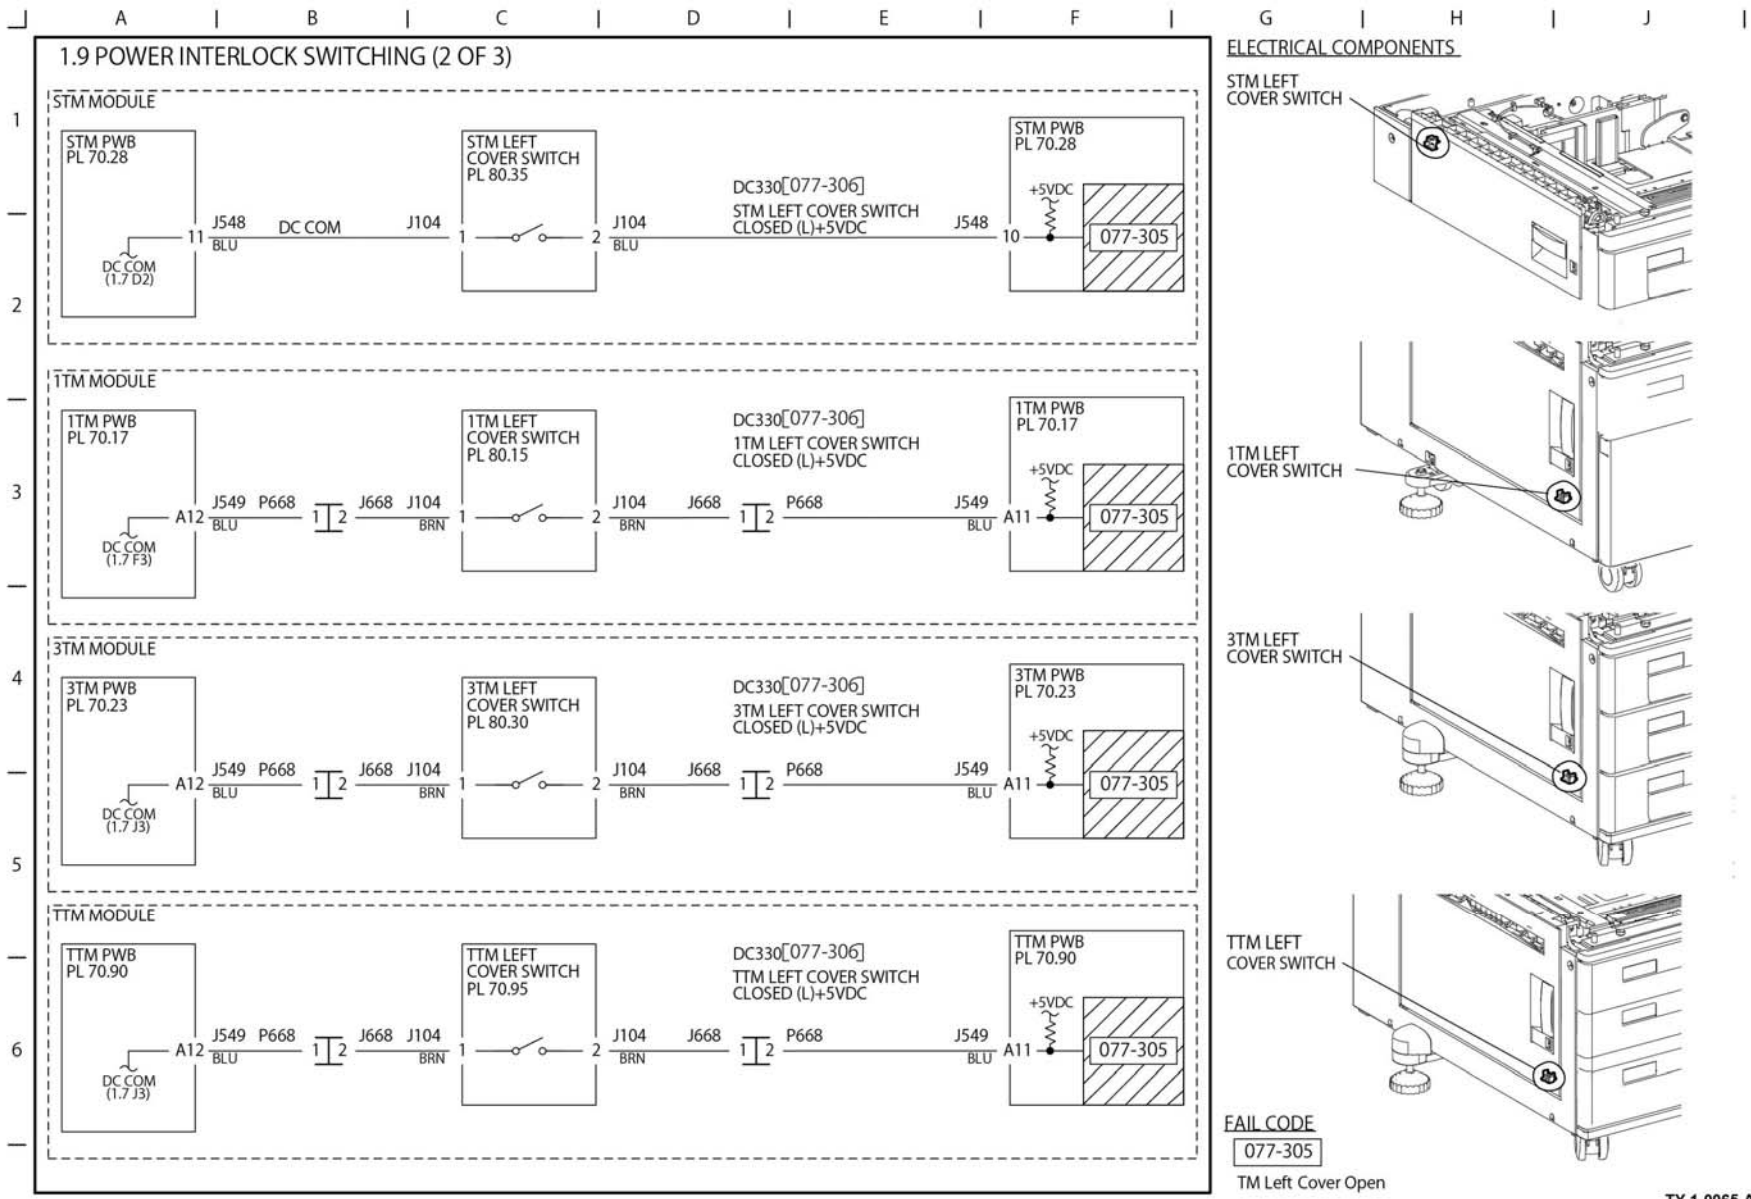
Figure 10 BSD 1.9

BSD 1.9 Power Interlock Switching (2 of 3)

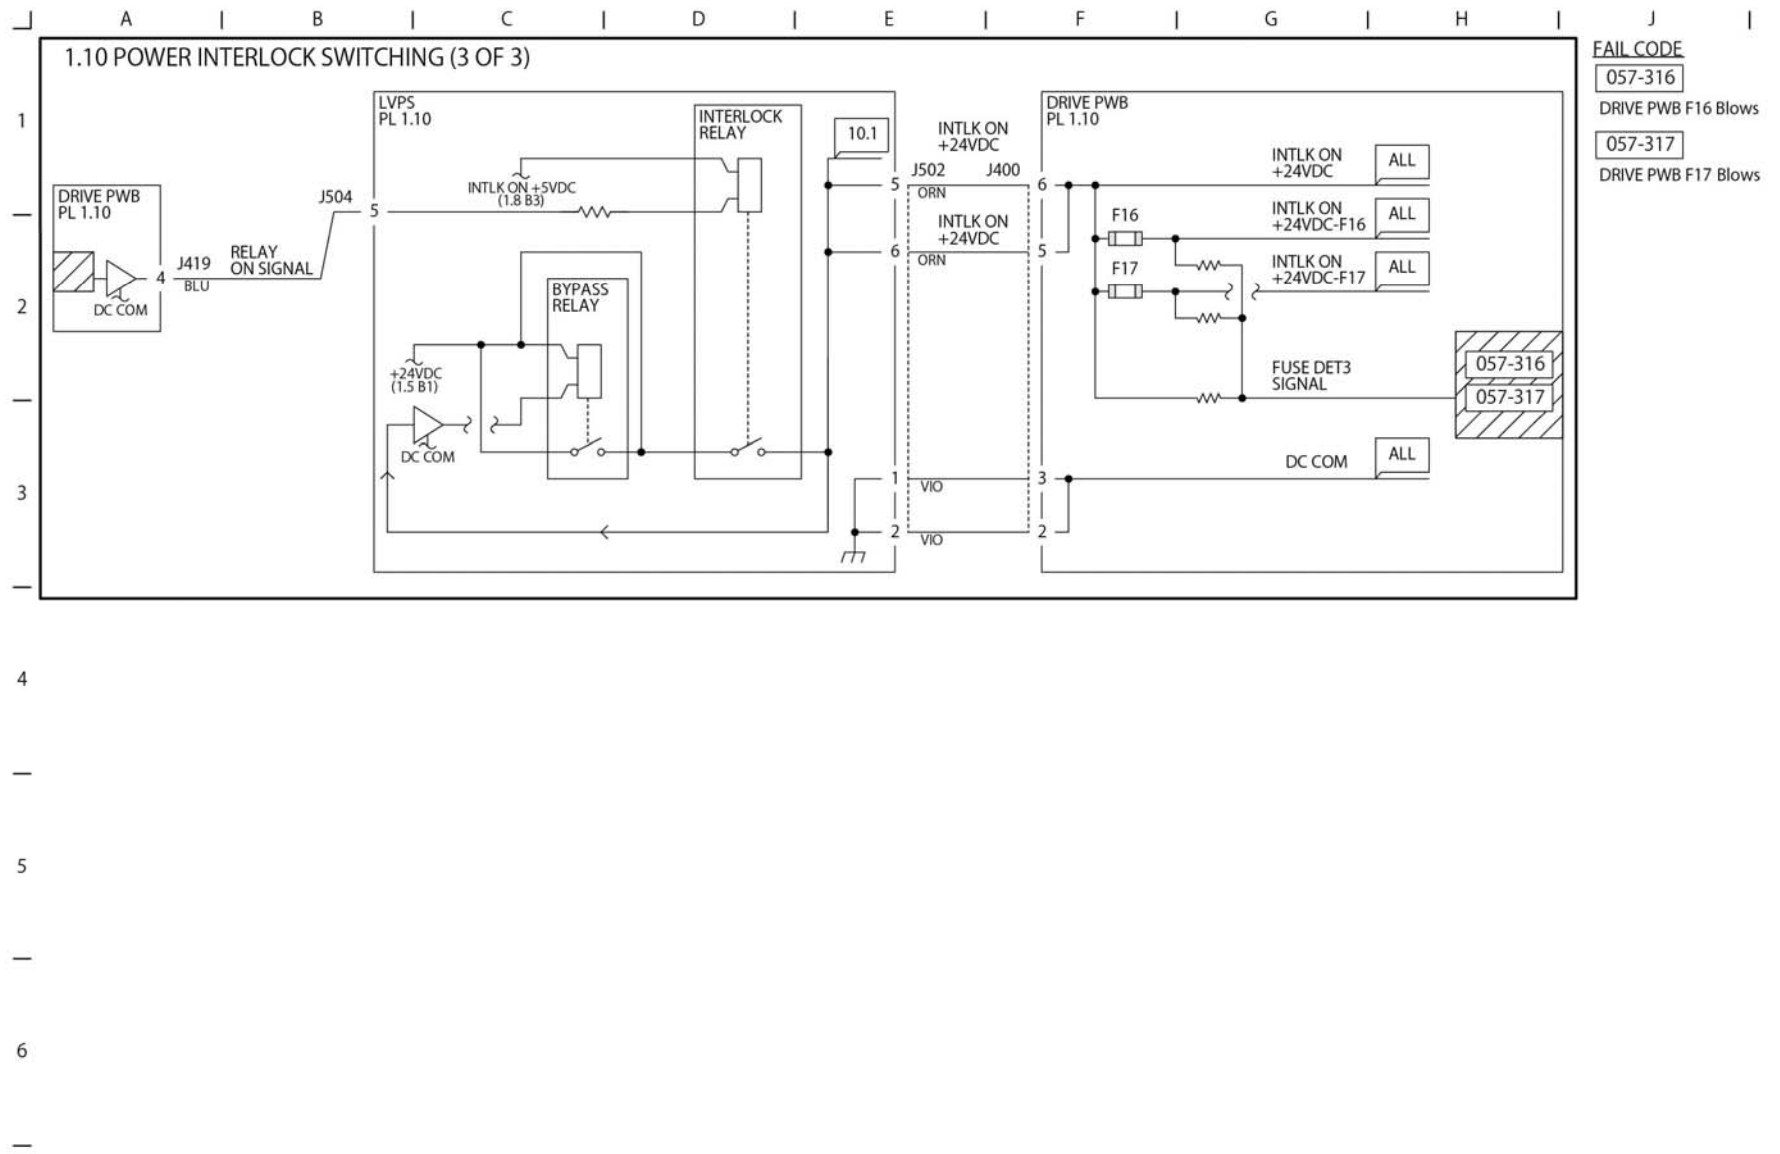
Figure 11 BSD 1.10

BSD 1.10 Power Interlock Switching (3 of 3)

FAIL CODE
 057-316
 DRIVE PWB F16 Blows
 057-317
 DRIVE PWB F17 Blows

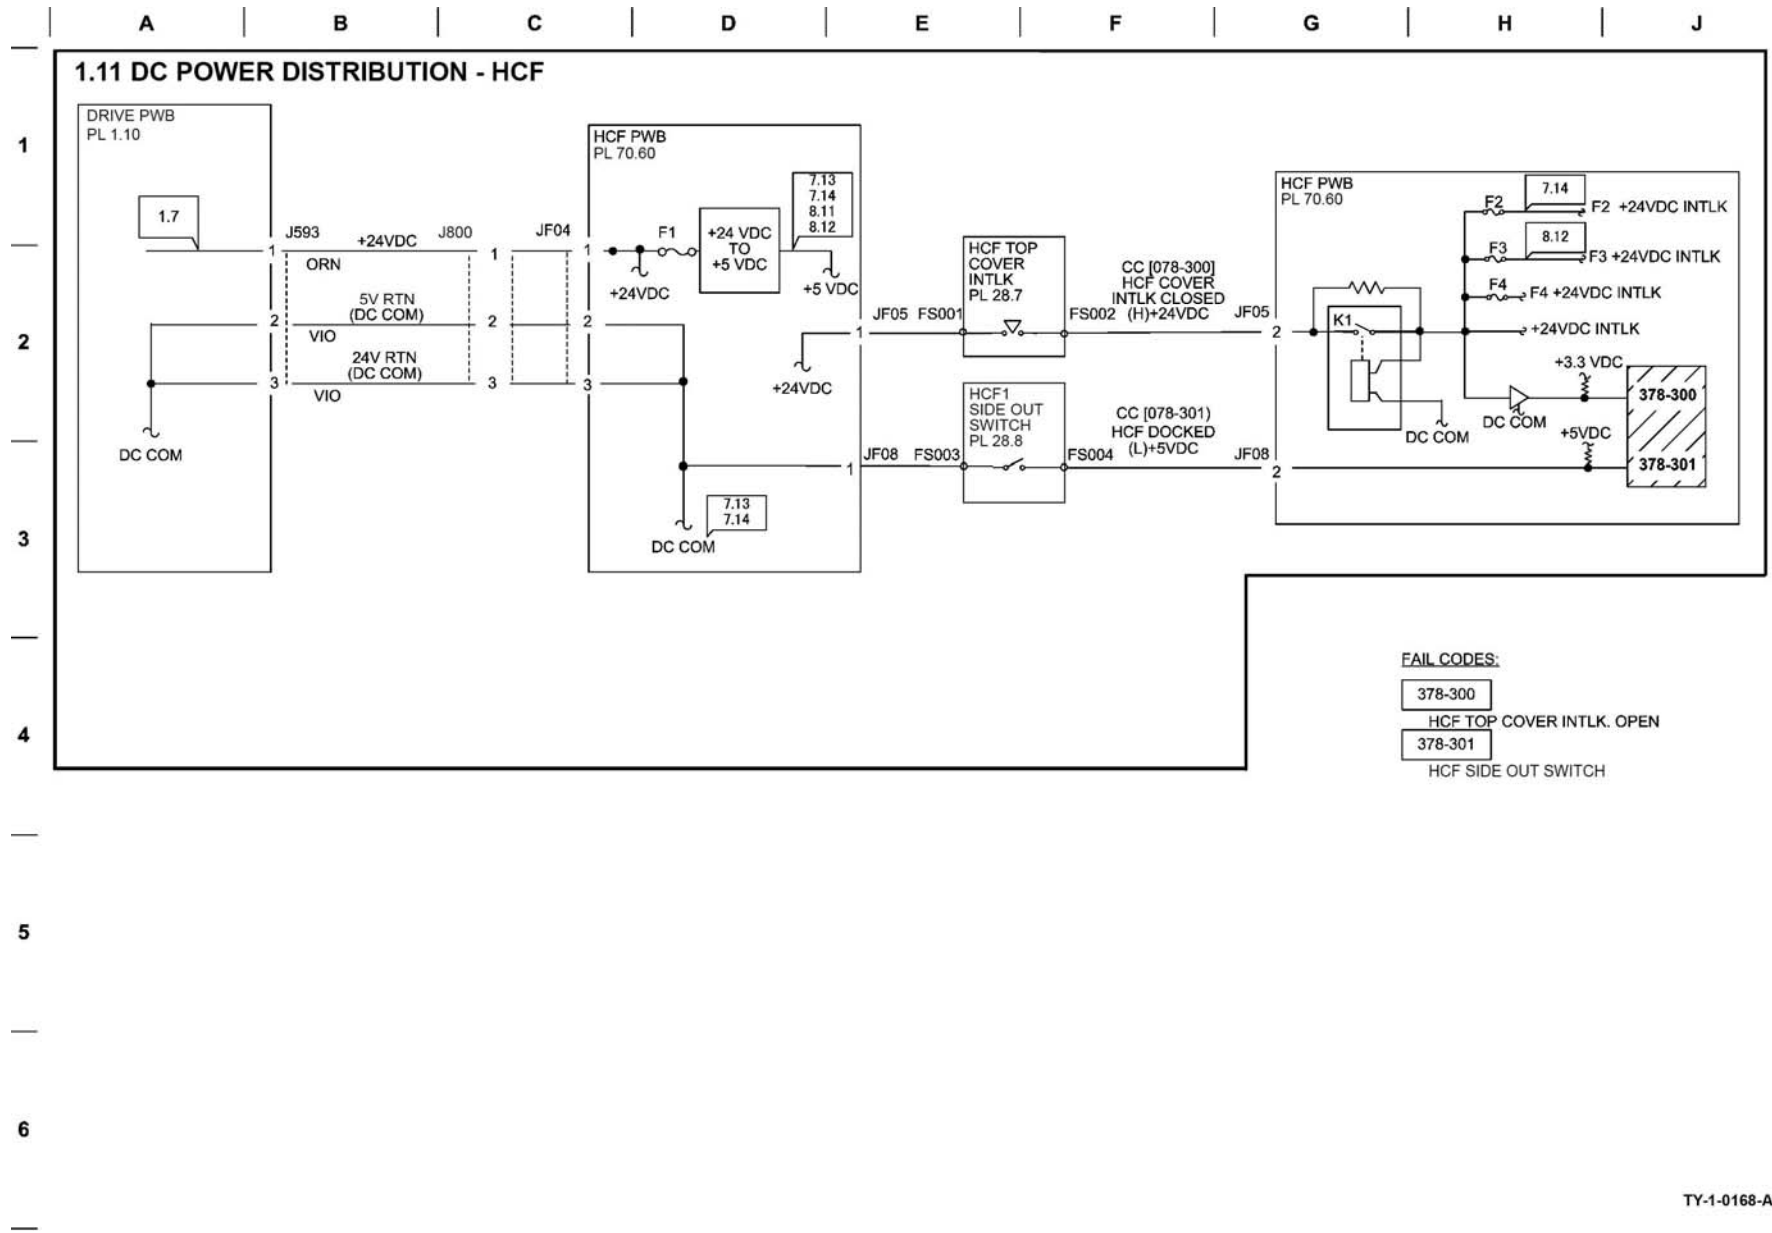
Figure 12 BSD 1.11

BSD 1.11 DC Power Distribution - HCF

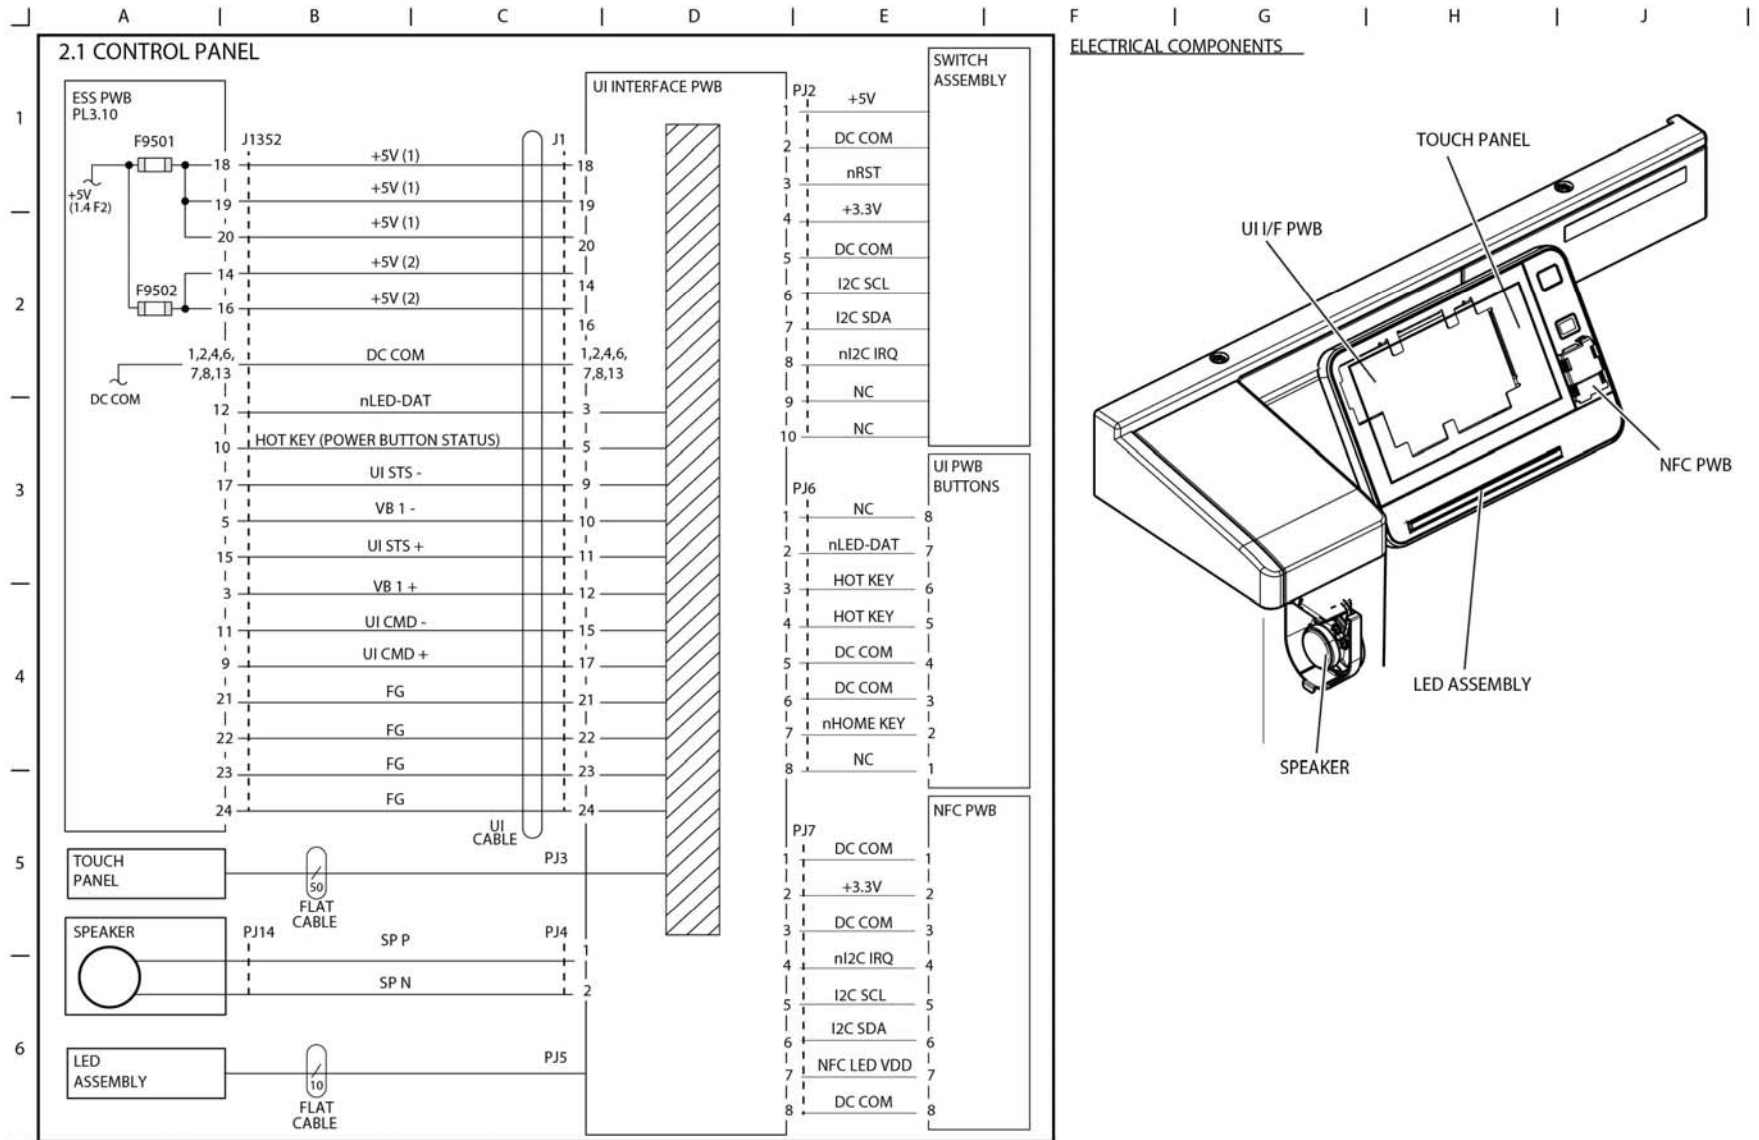
Figure 13 BSD 2.1

BSD 2.1 Control Panel

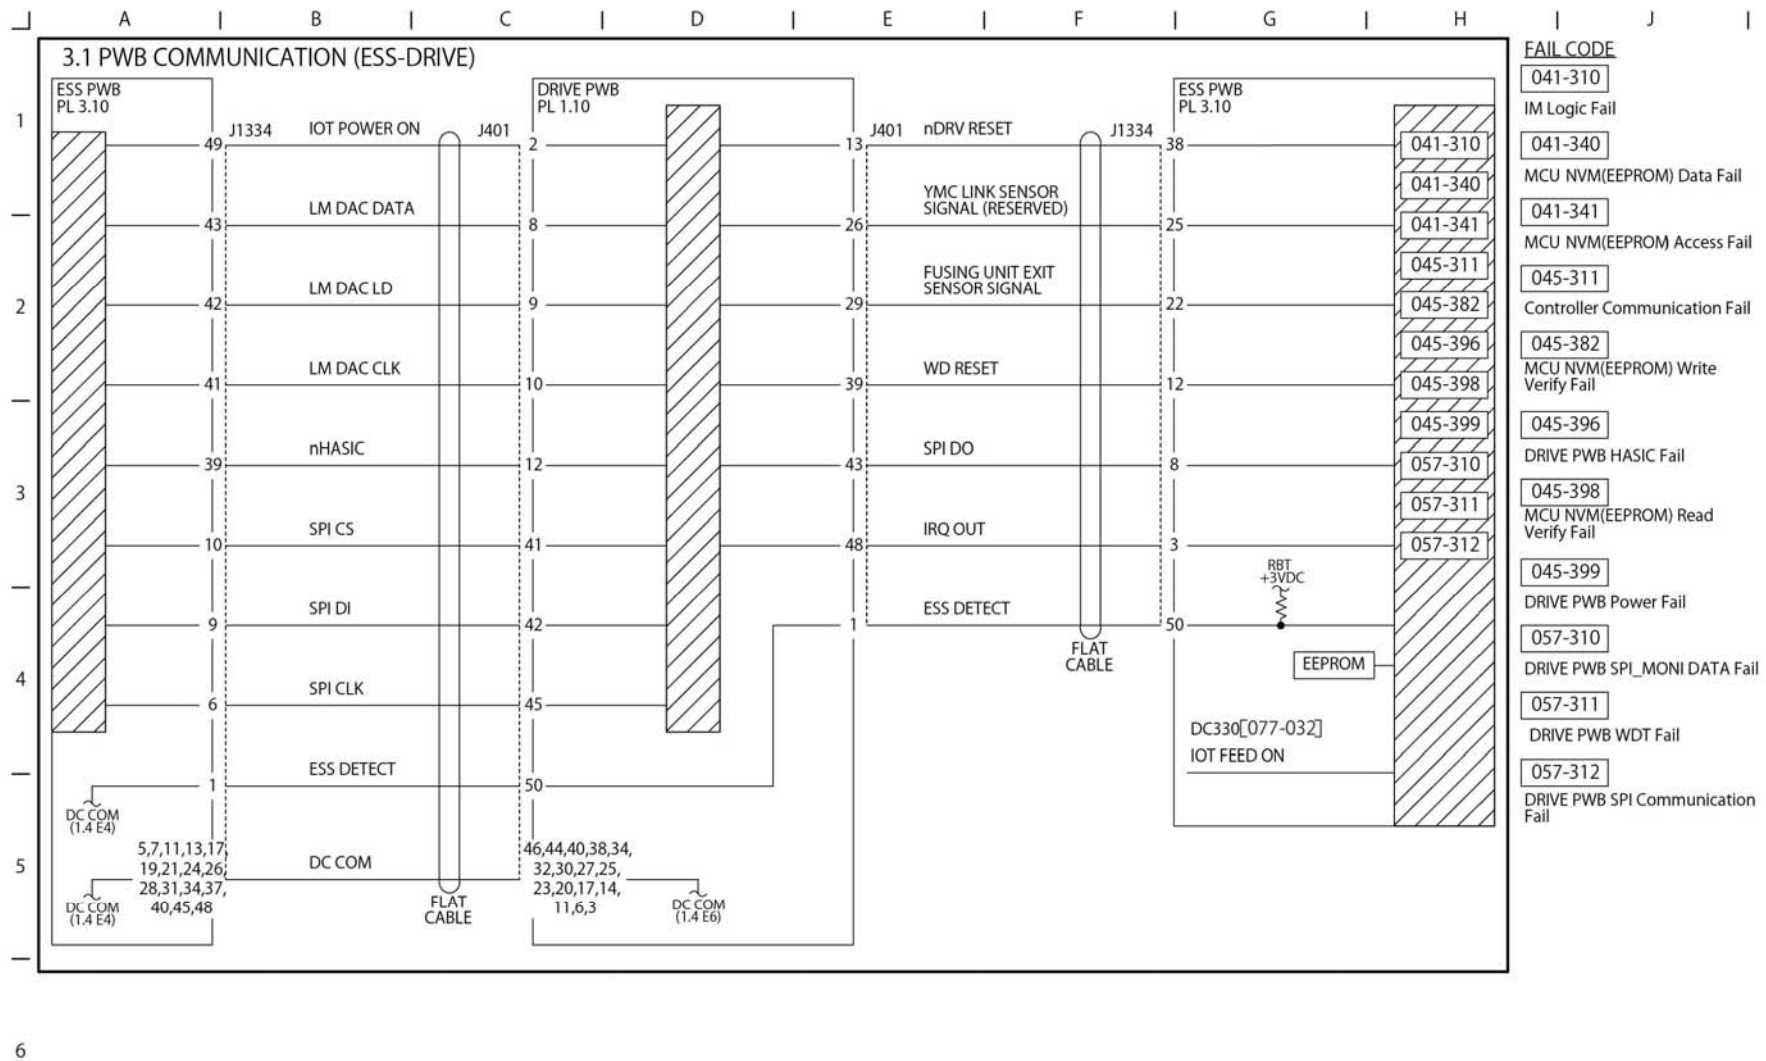
Figure 14 BSD 3.1

BSD 3.1 PWB Communications (ESS PWB to Drive PWB)
