708P91370
April 2017

Xerox® VersaLink® B7025/B7030/B7035 Multifunction Printer Service Manual

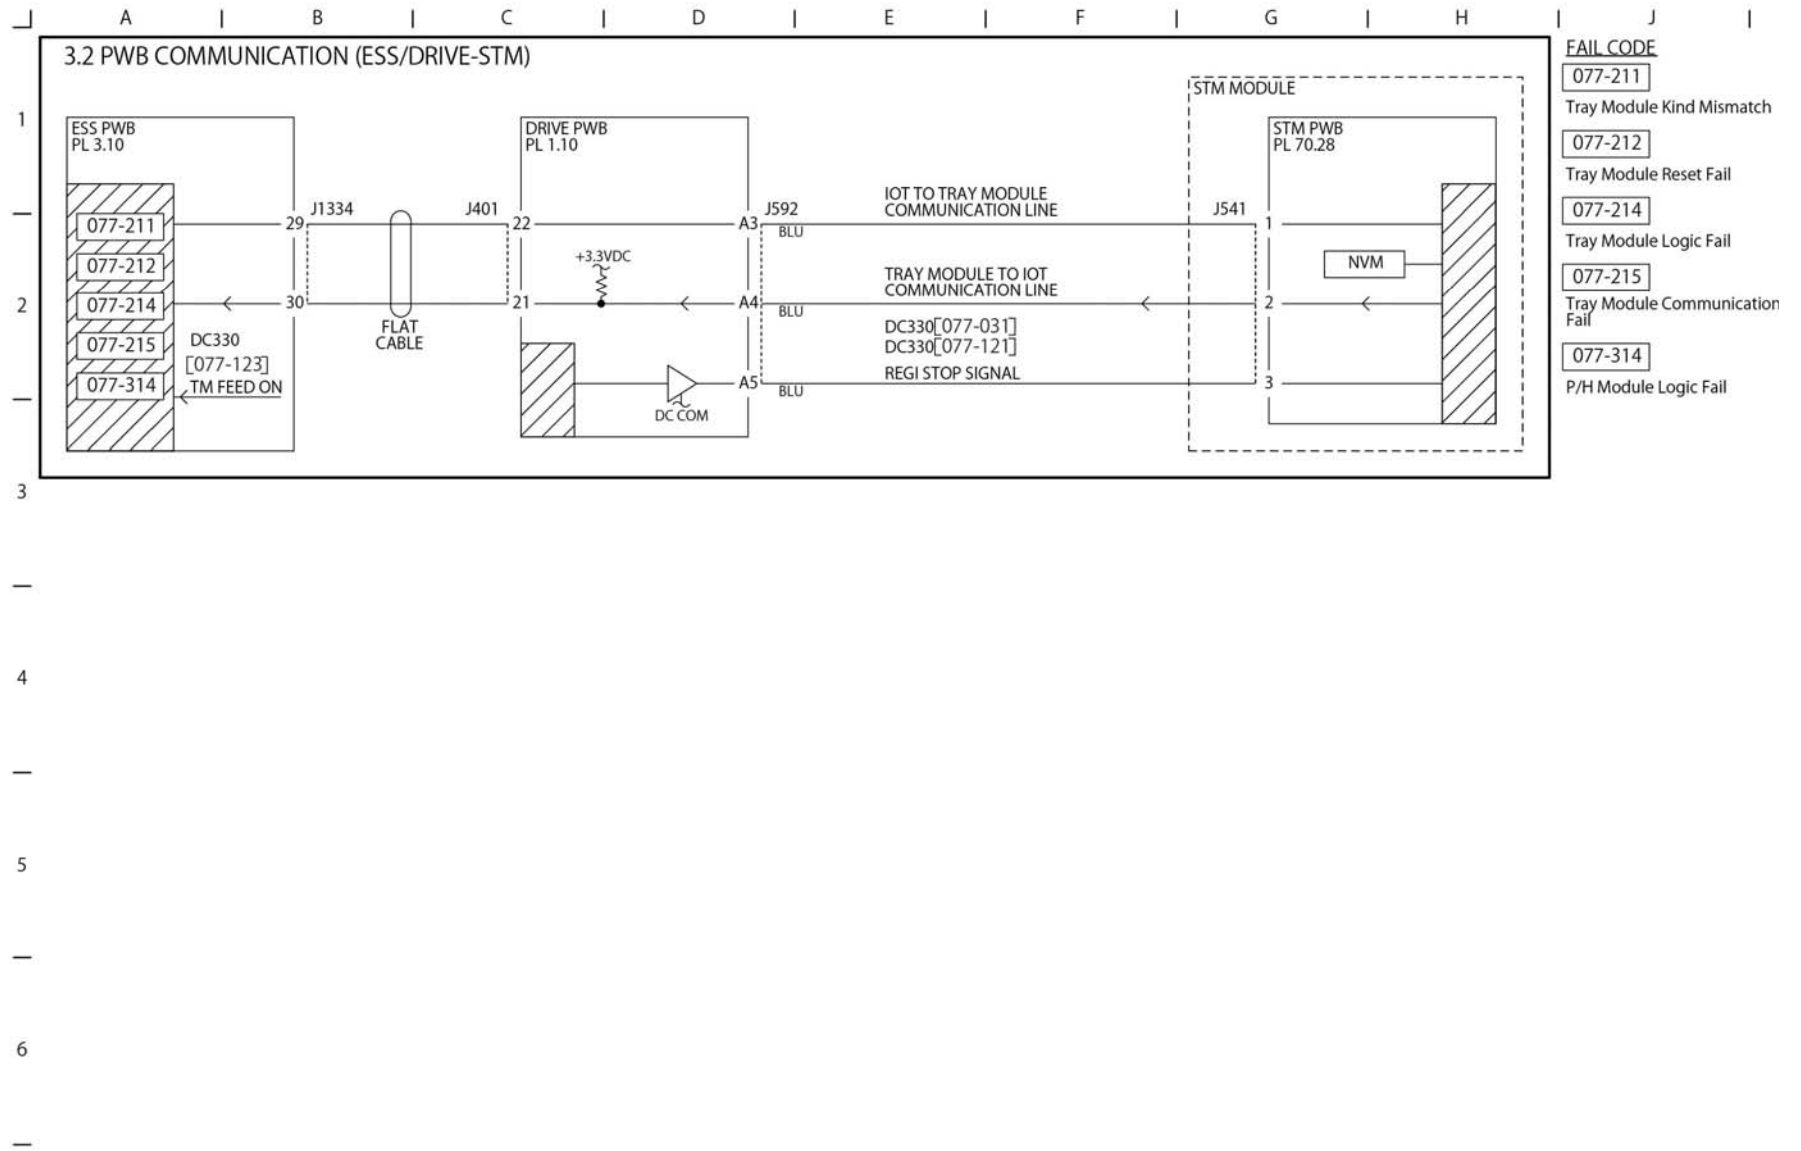
Figure 15 BSD 3.2

BSD 3.2 PWB Communications (ESS PWB/Drive PWB to STM)

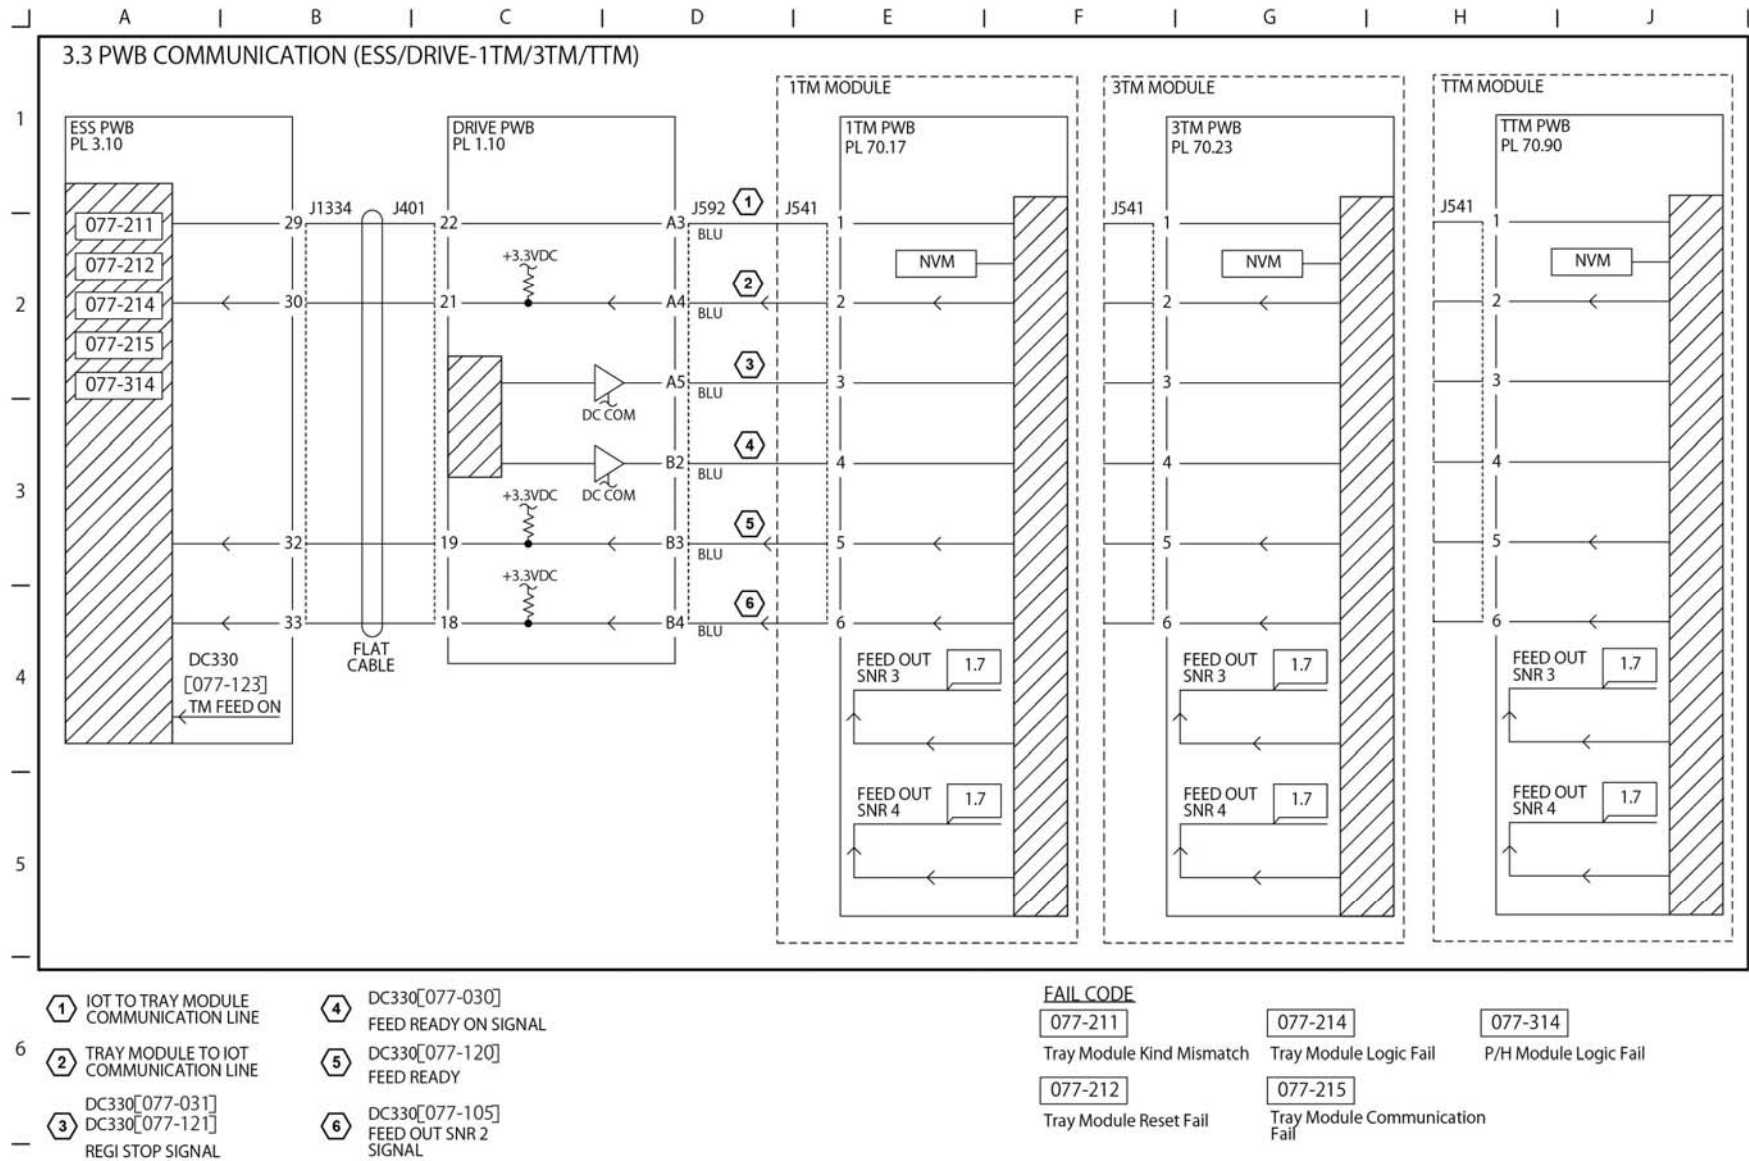
Figure 16 BSD 3.3

BSD 3.3 PWB Communications (ESS/Drive PWB to 1TM/3TM/TTM)

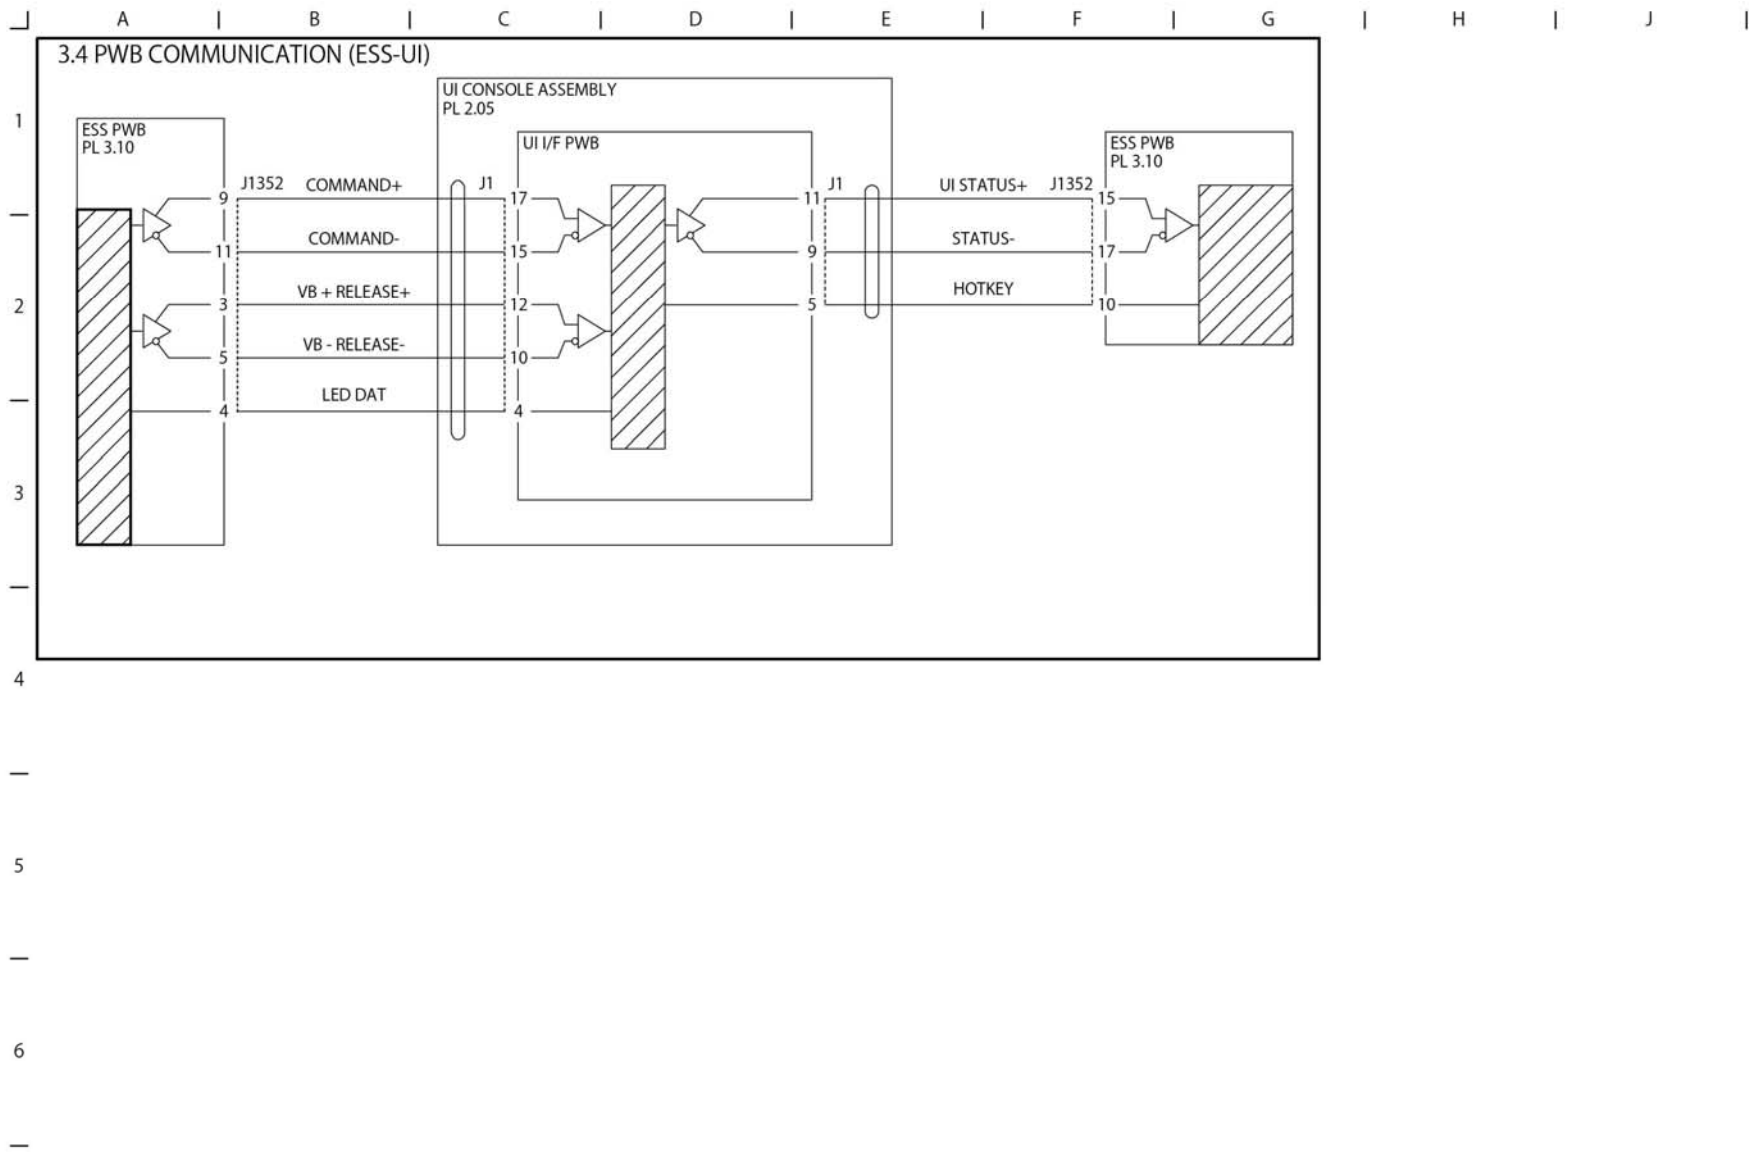
Figure 17 BSD 3.4

BSD 3.4 PWB Communications (ESS PWB to UI)

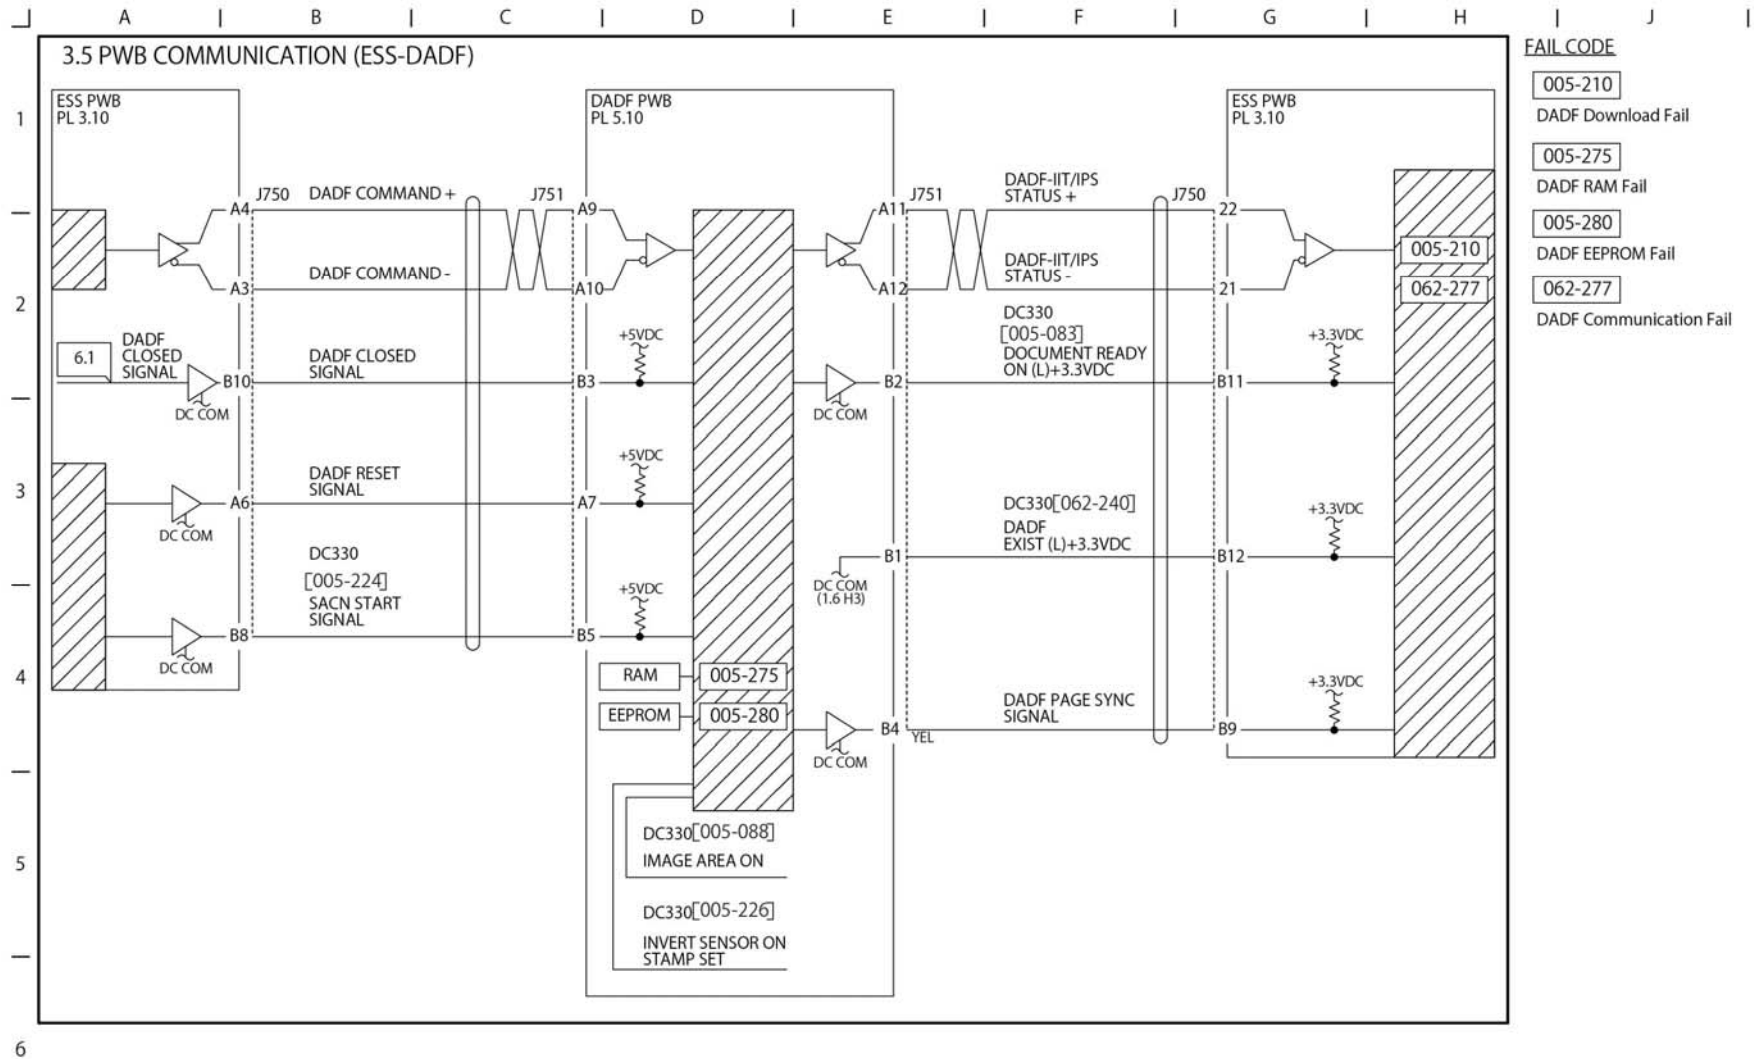
Figure 18 BSD 3.5

BSD 3.5 PWB Communications (ESS PWB to DADF)

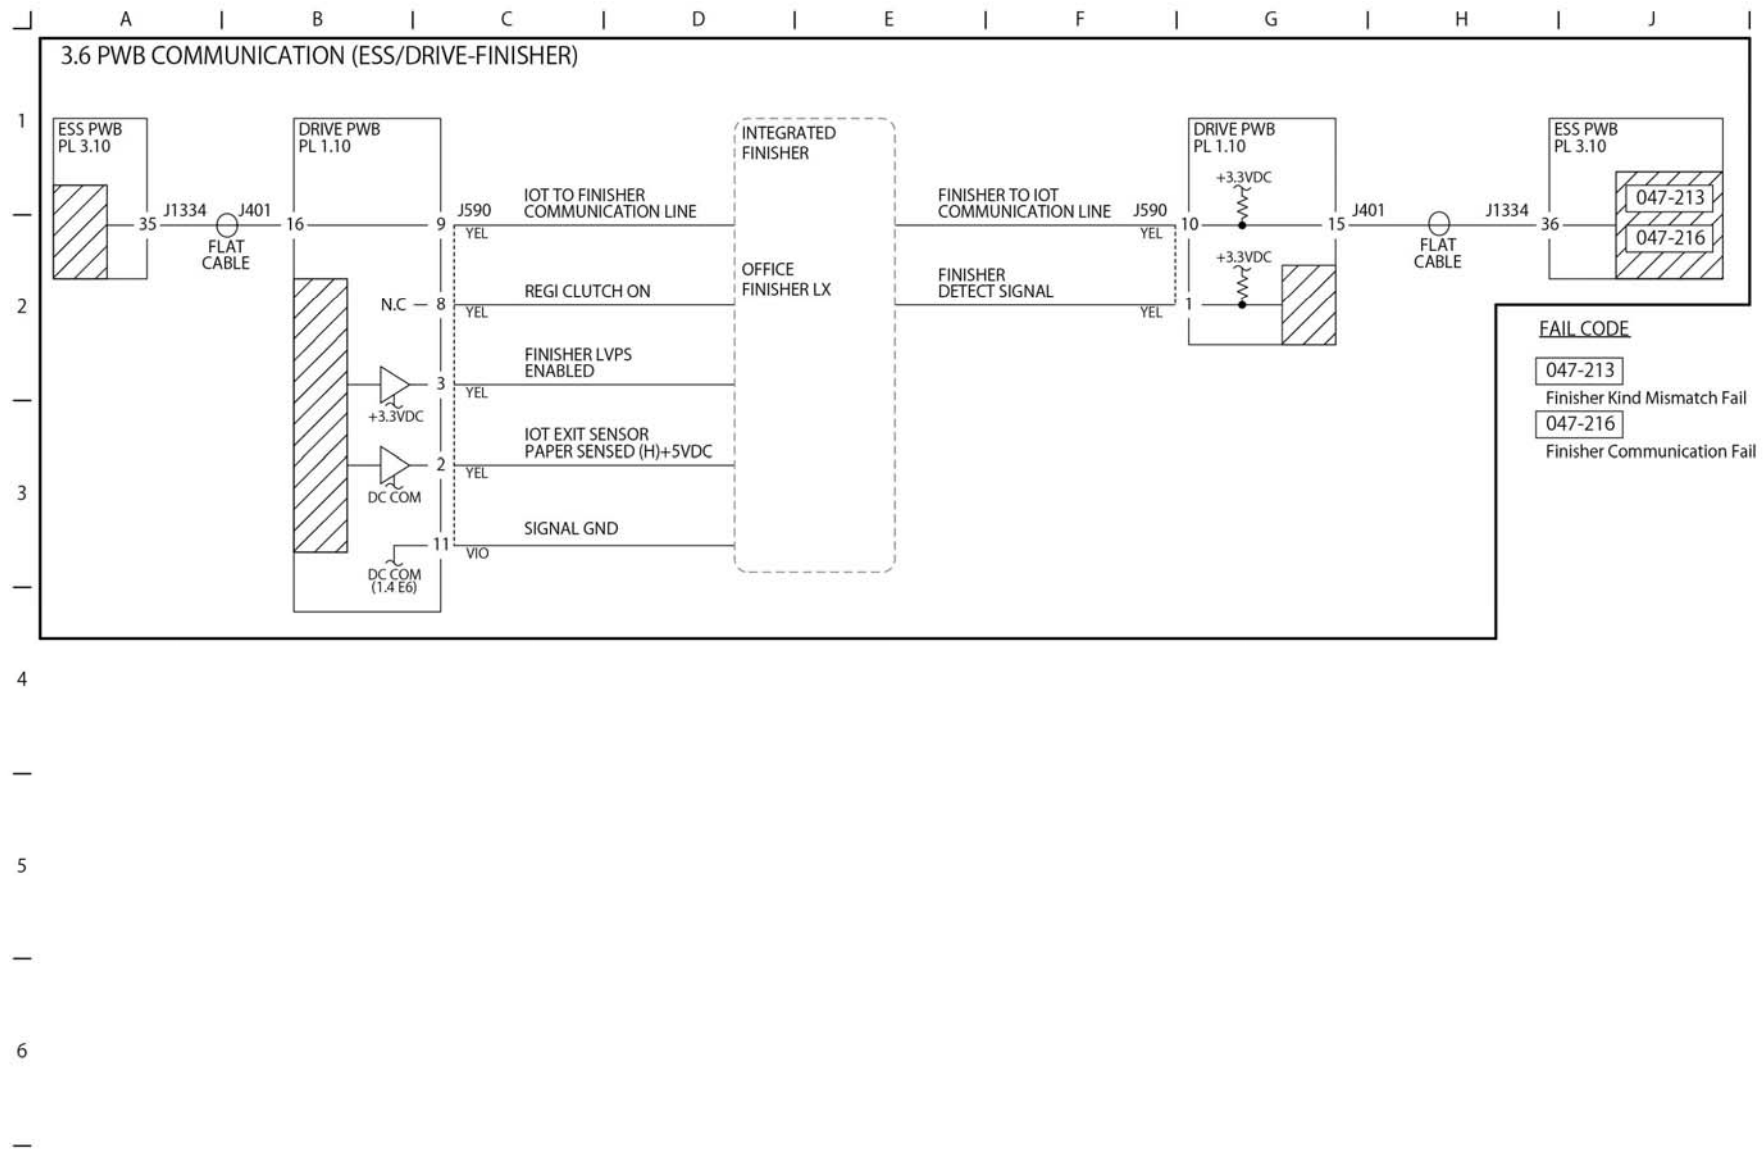
Figure 19 BSD 3.6

BSD 3.6 PWB Communications (ESS PWB/Drive PWB to Finisher)

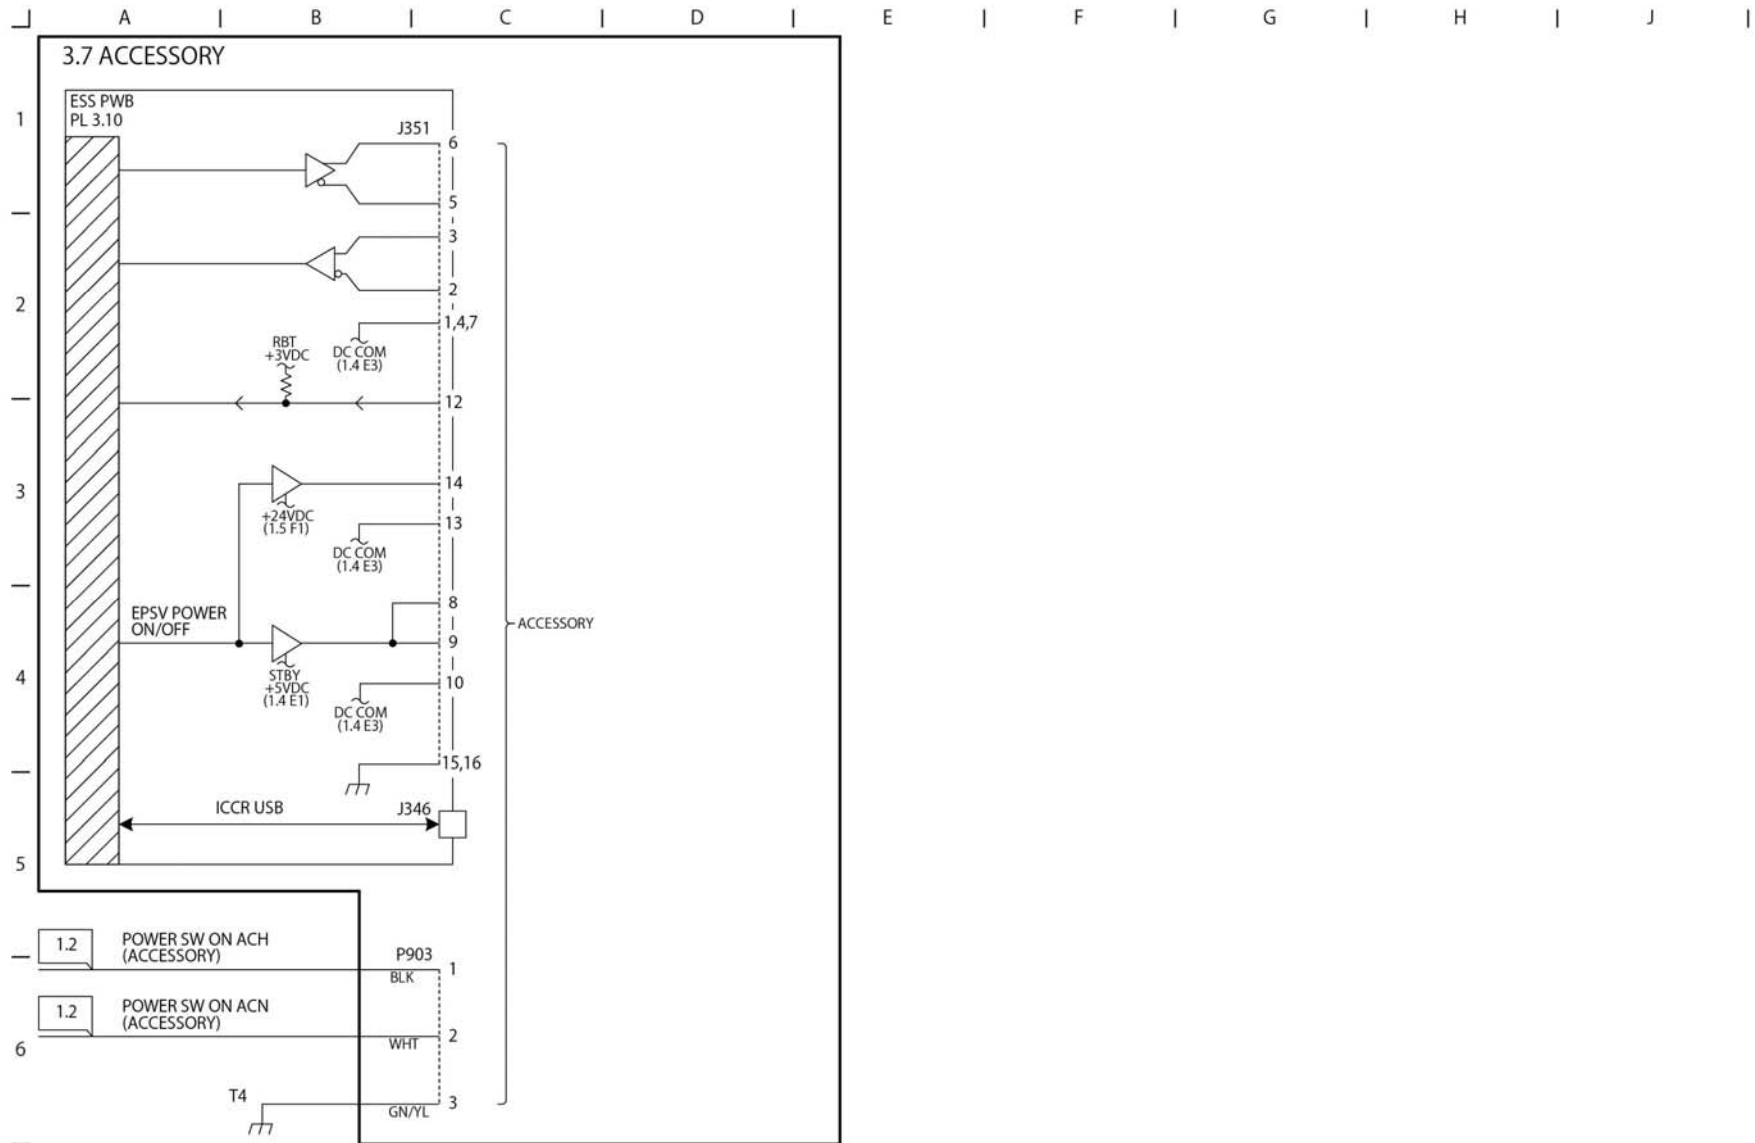
Figure 20 BSD 3.7

BSD 3.7 Accessory

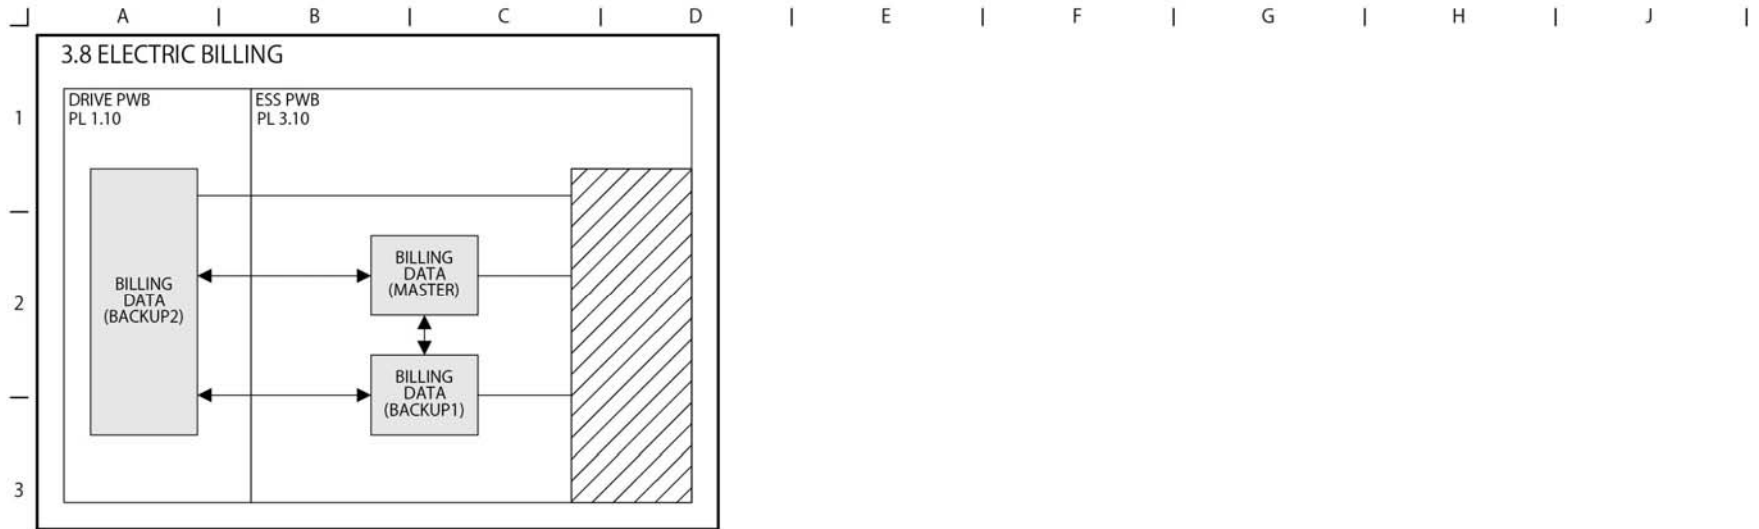
Figure 21 BSD 3.8

BSD 3.8 Electric Billing

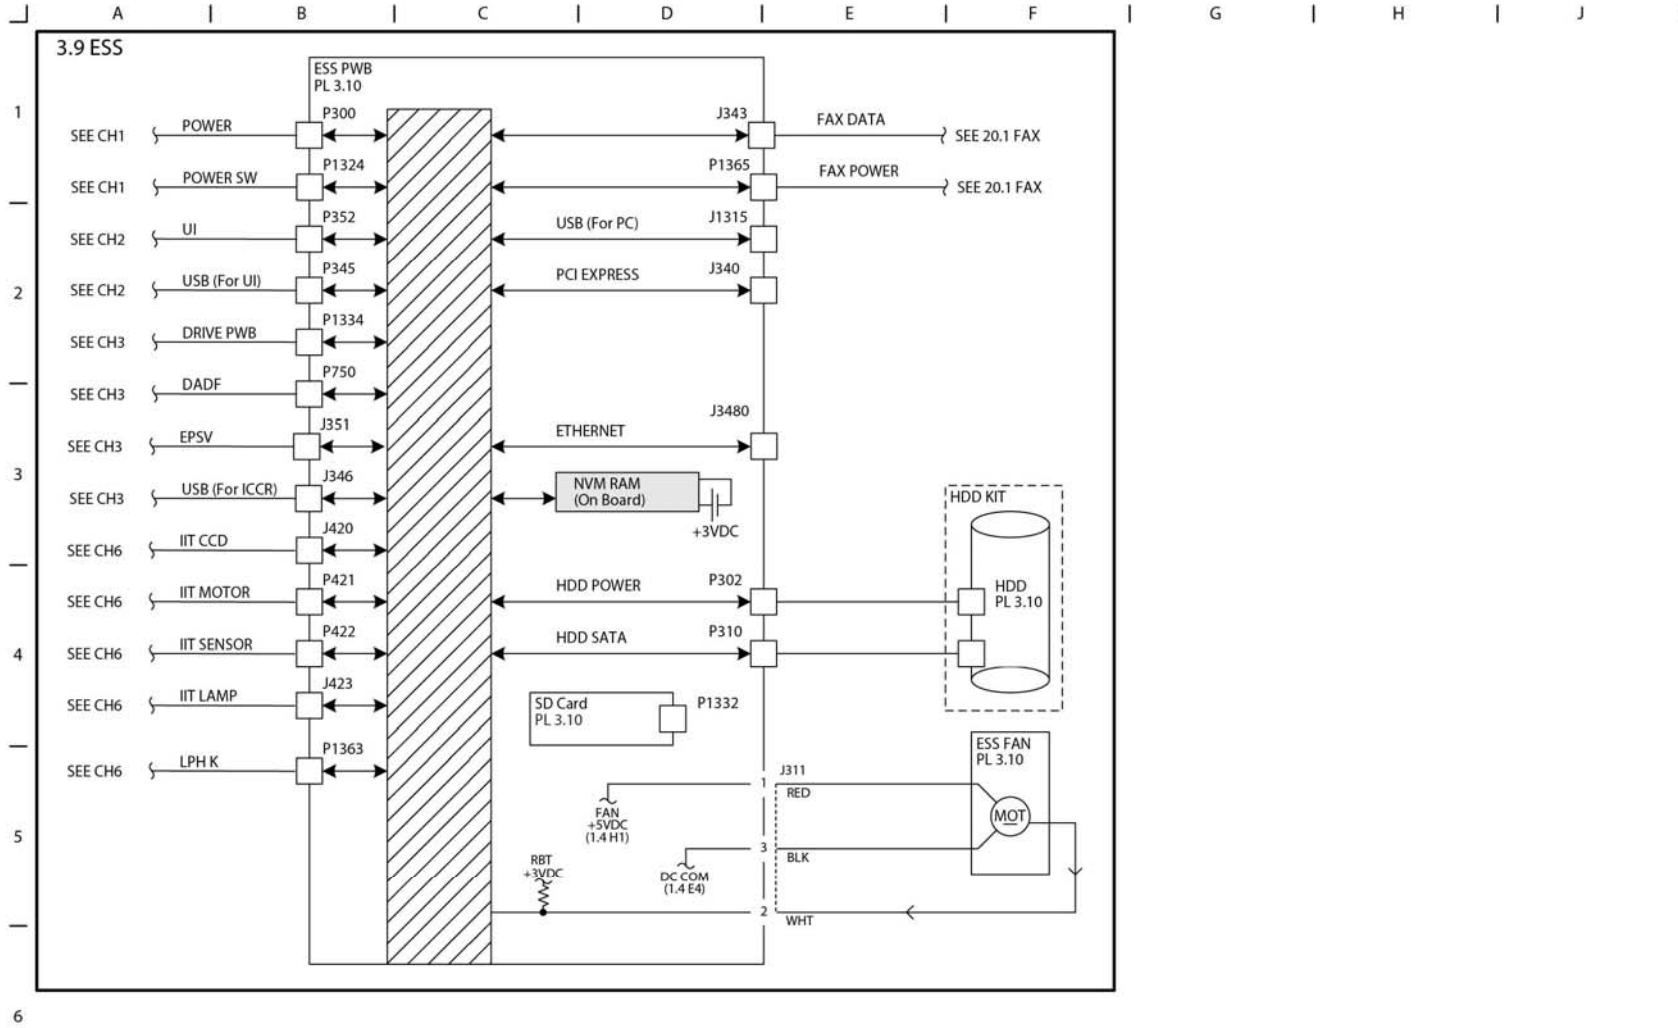
Figure 22 BSD 3.9

BSD 3.9 ESS

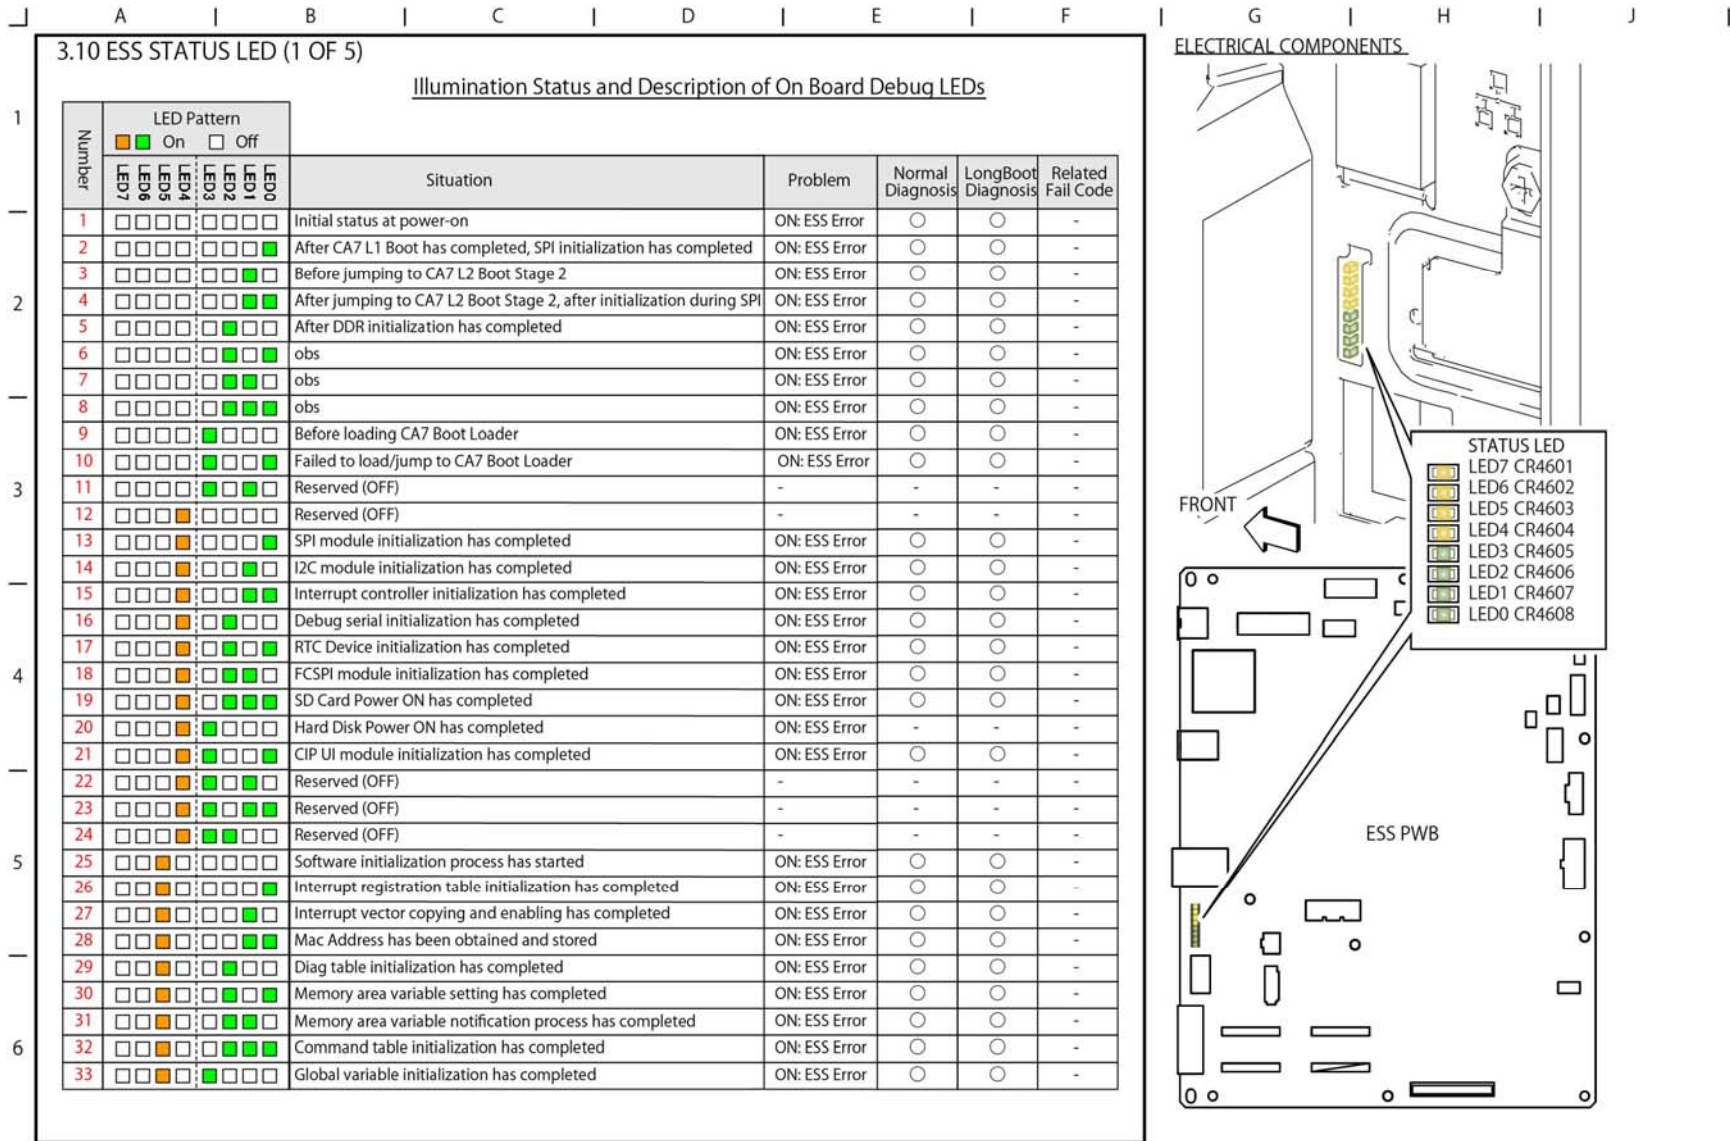
Figure 23 BSD 3.10

BSD 3.10 ESS Status LED (1 of 5)

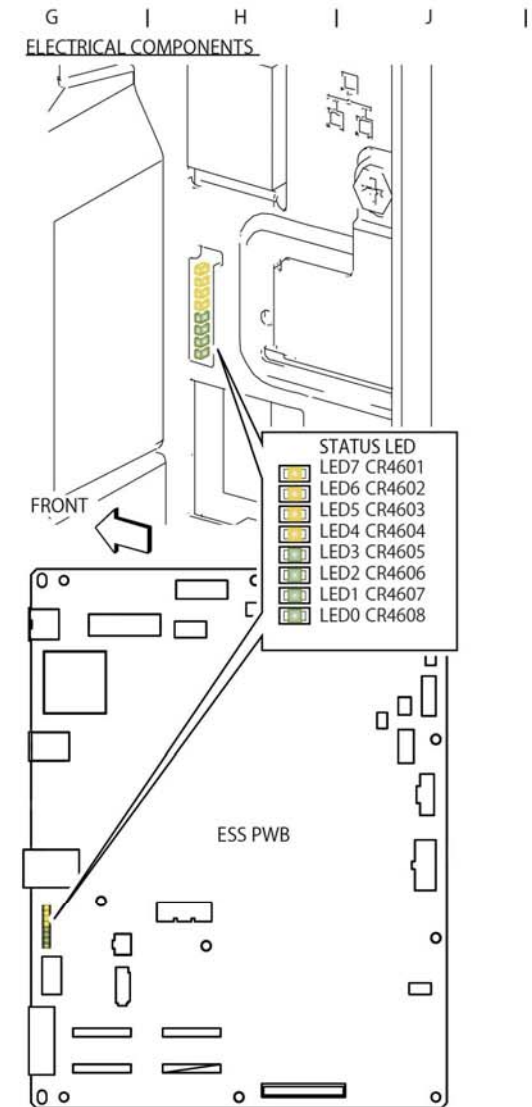
Figure 24 BSD 3.11

BSD 3.11 ESS Status LED (2 of 5)

3.11 ESS STATUS LED (2 OF 5)		Illumination Status and Description of On Board Debug LEDs										
Number	LED Pattern							Situation	Problem	Normal Diagnosis	LongBoot Diagnosis	Related Fail Code
	LED7	LED6	LED5	LED4	LED3	LED2	LED1					
34	□	□	□	□	□	□	□	Reserved (OFF)	-	-	-	-
35	□	□	□	□	□	□	□	Reserved (OFF)	-	-	-	-
36	□	□	□	□	□	□	□	JUMP to Mini OS section	ON: ESS Error	○	○	-
37	□	□	□	□	□	□	□	JUMP to Panbug Main section	ON: ESS Error	○	○	-
38	□	□	□	□	□	□	□	Reserved (OFF)	-	-	-	-
39	□	□	□	□	□	□	□	Reserved (OFF)	-	-	-	-
40	□	□	□	□	□	□	□	0xFF -> 0x00 is repeating alternately. DDR initialization process has failed	Flashing: ESS Error	○	○	-
41	□	□	□	□	□	□	□	0xF0 -> 0x0F is repeating alternately. Boot Loader checksum error - L2 Boot has read a Boot Loader checksum error from FCSPi	Flashing: ESS Error	○	○	-
42	□	□	□	□	□	□	□	CA15-0: (0xA0 -> 0x05 is repeating alternately. CPLD is showing an invalid boot mode.	Flashing: ESS Error	○	○	-

43	□	□	□	□	□	□	□	CA15-0: After the recovery from Switch OFF mode is detected by CPLD flag, before proceeding to read the NVM recovery data.	ON: ESS Error	-	-	-
44	□	□	□	□	□	□	□	CA15-0: After reading the NVM recovery data, before calculating the checksum on the DDR.	ON: ESS Error	-	-	-
45	□	□	□	□	□	□	□	CA15-0: Immediately before jumping to the Switch OFF recovery point.	ON: ESS Error	-	-	-
46	□	□	□	□	□	□	□	CA15-0: (0xC0 -> 0x03 is repeating alternately. Checksum error during recovery from Switch OFF mode.	Flashing: ESS Error	○	○	-
47	□	□	□	□	□	□	□	CA15-0: After the recovery from CPU OFF mode is detected by CPLD flag, before proceeding to read the NVM recovery data.	ON: ESS Error	-	-	-
48	□	□	□	□	□	□	□	CA15-0: After reading the NVM recovery data, before calculating the checksum on the DDR.	ON: ESS Error	-	-	-
49	□	□	□	□	□	□	□	obs	ON: ESS Error	-	-	-
50	□	□	□	□	□	□	□	obs	ON: ESS Error	-	-	-
51	□	□	□	□	□	□	□	obs	ON: ESS Error	-	-	-

52	□	□	□	□	□	□	□	CA15-0: Immediately before jumping to the CPU OFF recovery point.	ON: ESS Error	-	-	-
53	□	□	□	□	□	□	□	0x80 -> 0x01 is repeating alternately. Stored data checksum error during recovery from CPU OFF mode.	Flashing: ESS or RAM Error	-	-	-
54	□	□	□	□	□	□	□	0xE0 -> 0x07 is repeating alternately. Other error has occurred at CA15, L2 Boot.	Flashing: ESS or RAM Error	-	-	-
55	□	□	□	□	□	□	□	SD module initialization has started	Flashing: RAM or SD Card Error	○	○	117-319
56	□	□	□	□	□	□	□	SD Card Power ON has completed	Flashing: RAM or SD Card Error	○	○	117-319
57	□	□	□	□	□	□	□	SD module initialization has completed	Flashing: RAM or SD Card Error	○	○	117-319
58	□	□	□	□	□	□	□	SD Card driver error	Flashing: RAM or SD Card Error	○	○	117-319
59	□	□	□	□	□	□	□	An unsupported SD Card is inserted	Flashing: RAM or SD Card Error	○	○	117-321

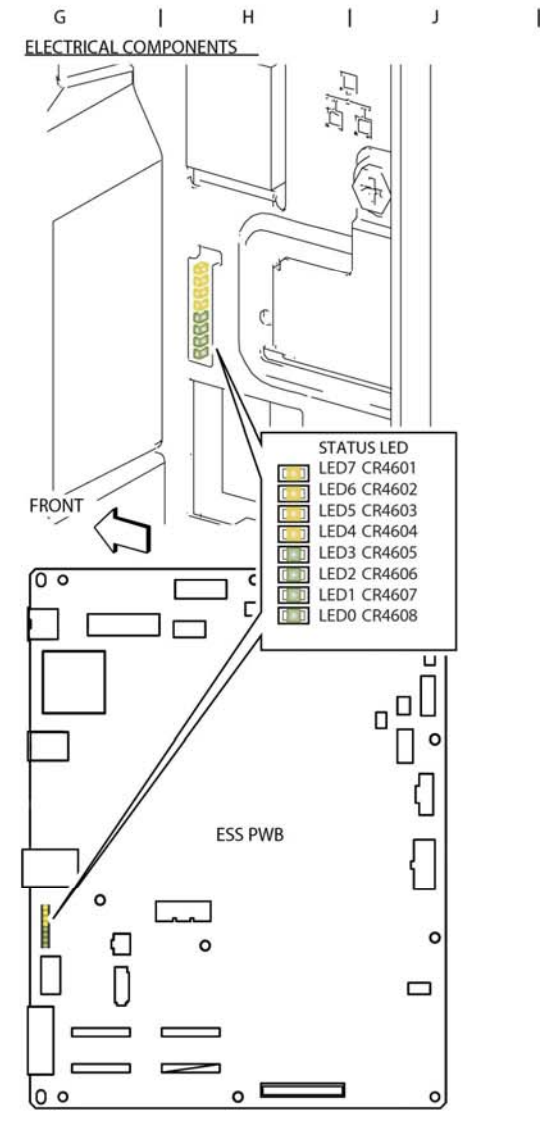
Figure 25 BSD 3.12

3.12 ESS STATUS LED (3 OF 5)							
Illumination Status and Description of On Board Debug LEDs							
Number	LED Pattern						
	LED7	LED6	LED5	LED4	LED3	LED2	LED1
	On	Off	On	Off	On	Off	On
	Situation	Problem	Normal Diagnosis	LongBoot Diagnosis	Related Fail Code		
60	On On On On On	SD Card is not inserted (not detected)	Flashing: RAM or SD Card Error	☒	☒	117-329	
61	On On On On Off	Reserved (OFF)	-	-	-		
62	On On On Off On	Reserved (OFF)	-	-	-		
63	On On On Off Off	Reserved (OFF)	-	-	-		
64	On On Off On On	Reserved (OFF)	-	-	-		
65	On On Off On Off	SD module initialization has completed	Flashing: RAM or SD Card Error	☒	☒	117-319	
66	On On Off Off On	Read process from SD Card has started	Flashing: RAM or SD Card Error	☒	☒	117-319	
67	On On Off Off Off	SD module initialization check has completed	Flashing: RAM or SD Card Error	☒	☒	117-319	
68	On On Off On On	A15 Program memory expansion has completed	Flashing: RAM or SD Card Error	☒	☒	117-319

69	On On Off On Off	A7 Program memory expansion has completed	Flashing: RAM or SD Card Error	☒	☒	-	
70	On On Off Off Off	BackPlane Disconnect Detection	ON: BackPlane Connection Error	☒	☒	16-327	
71	On On Off Off On	UI Cable Disconnect Detection	ON: UI Cable Connection Error	☒	☒	16-326	
72	On On Off Off Off	MCU Harness Disconnect Detection	ON: MCU Harness Connection Error	☒	☒	16-328	
73	On On Off On On	Detects the connection of a device with unknown Pci Option	ON: Detected a Device that does not support Pci Option	☒	☒	117-336	
74	On On Off On Off	Detects the connection of a Device with unknown Pci EX Option	ON: Detected a Device that does not support Pci EX Option	☒	☒	117-337	
75	On On Off On On	SD Card Insertion Detection	ON: SD Card Connection Error	☒	☒	117-338	
76	On On Off Off Off	IO ASIC diagnostic has started	ON: ASIC Error	☒	☒	-	
77	On On Off Off On	IO ASIC diagnostic has completed	-	-	-		
78	On On Off Off Off	Codec ASIC diagnostic has started	ON: ASIC Error	☒	☒	-

79	On On Off Off On	Codec ASIC diagnostic has completed	-	-	-		
80	On On Off On On	Diagnosis of Standard Font ROM started	ON: ASIC Error	☒	☒	116-380	
81	On On Off On Off	Standard Font ROM diagnostic has completed	-	-	-		
82	On On Off On On	Extension Font ROM diagnostic has started	ON: ASIC Error	☒	☒	16-341	
83	On On Off On Off	Extension Font ROM diagnostic has completed	-	-	-		
84	On On Off On On	SEEP diagnostic has started	On: SEEPROM Error	-	☒	16-351 16-350	
85	On On Off On Off	SEEP diagnostic has completed	-	-	-		
86	On On Off On On	Timer diagnostic has started	ON: Timer Error	☒	☒	16-343	
87	On On Off On Off	Timer diagnostic has completed	-	-	-		
88	On On Off On On	Page Memory diagnostic has started	On: RAM Error	-	☒	16-317	
89	On On Off On Off	Page Memory diagnostic has completed	-	-	-		
90	On On Off On On	IIT IF diagnostic has started	On: IIT/ESS Error	-	☒	16-315 16-316 16-317 16-318 16-348

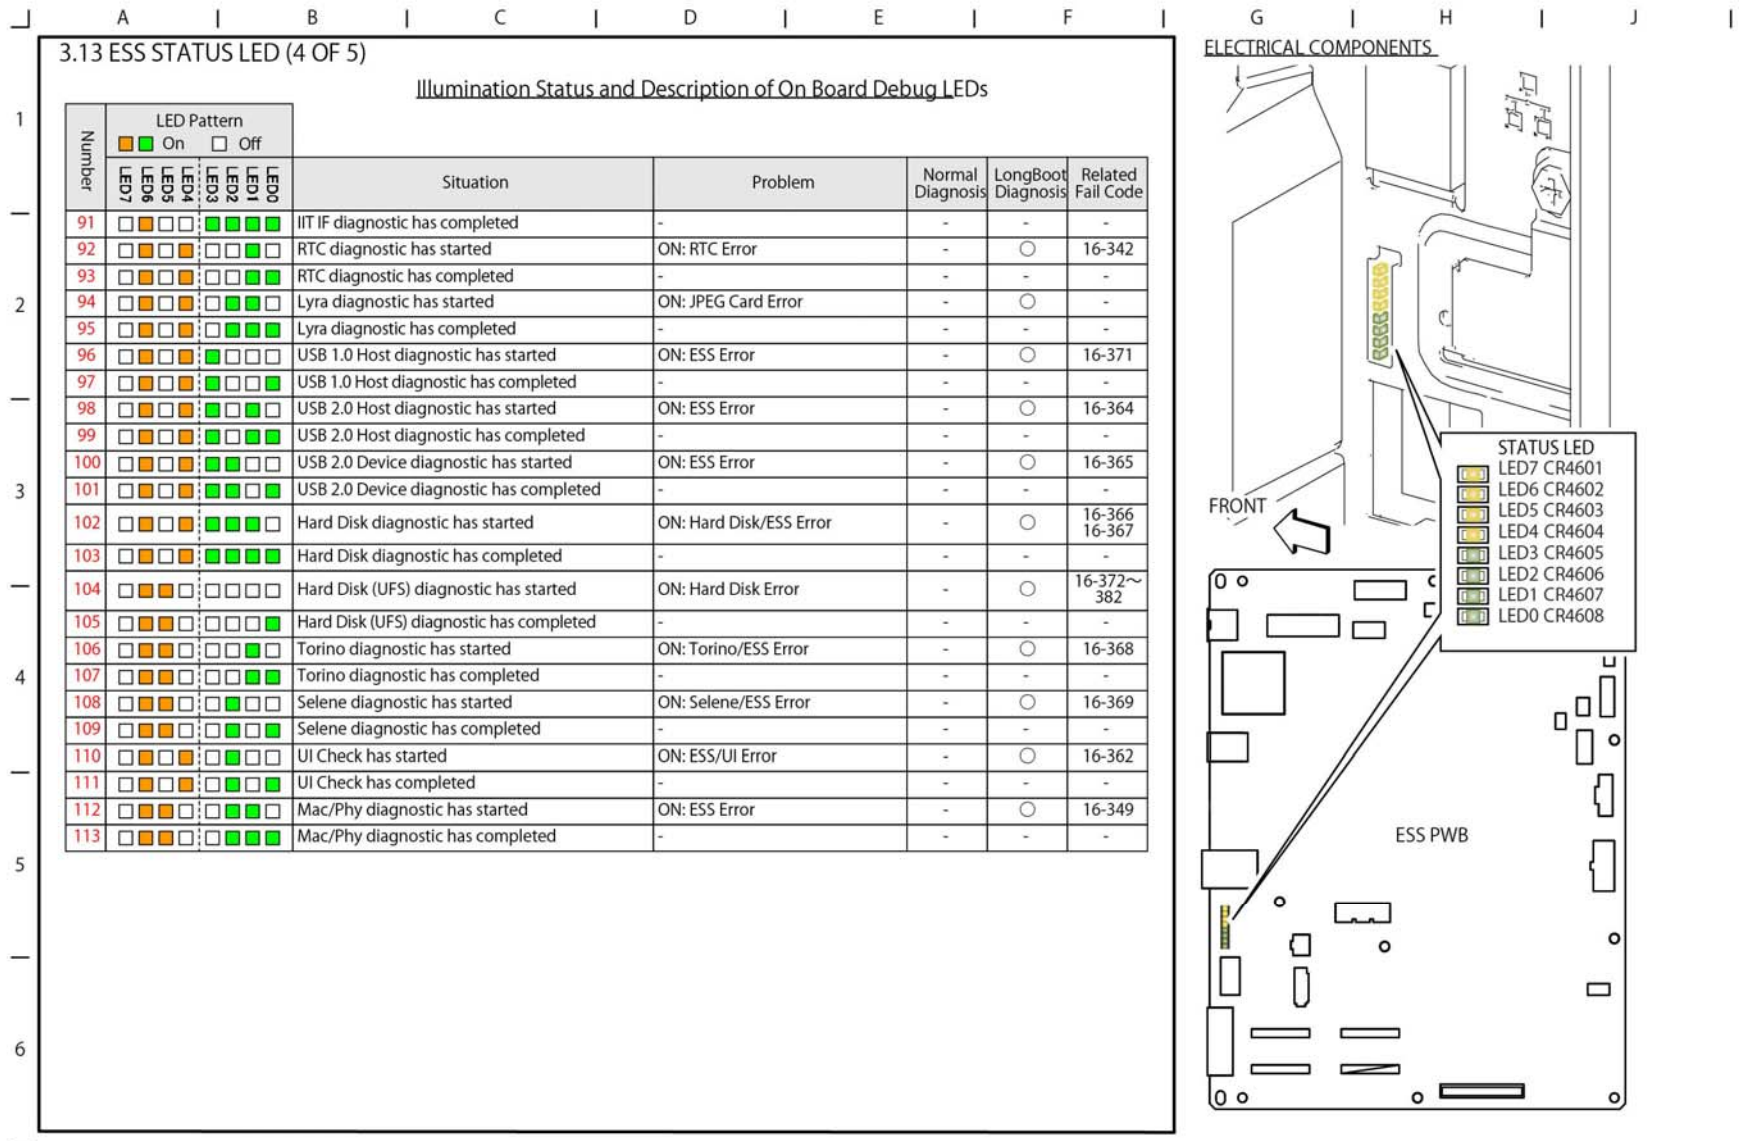
Figure 26 BSD 3.13

BSD 3.13 ESS Status LED (4 of 5)
