708P91370
April 2017

Xerox® VersaLink® B7025/B7030/B7035 Multifunction Printer Service Manual

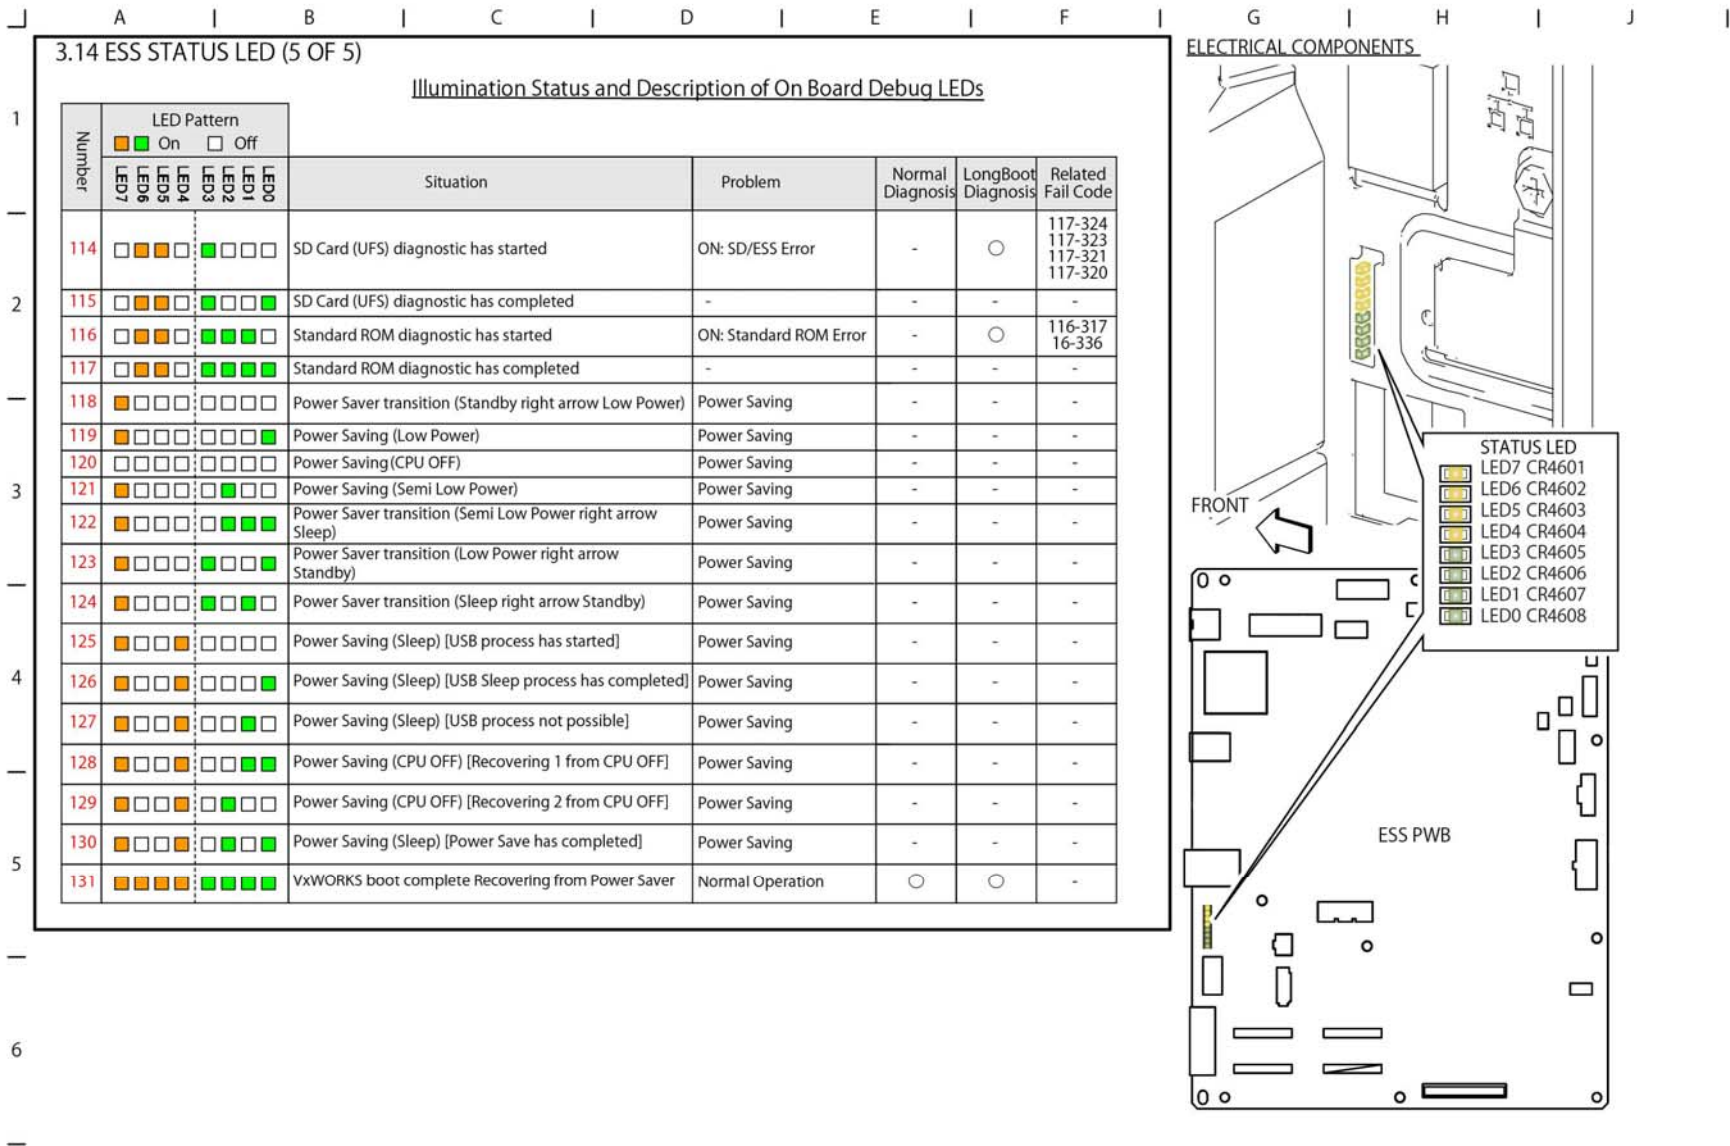
Figure 27 BSD 3.14

BSD 3.14 ESS Status LED (5 of 5)

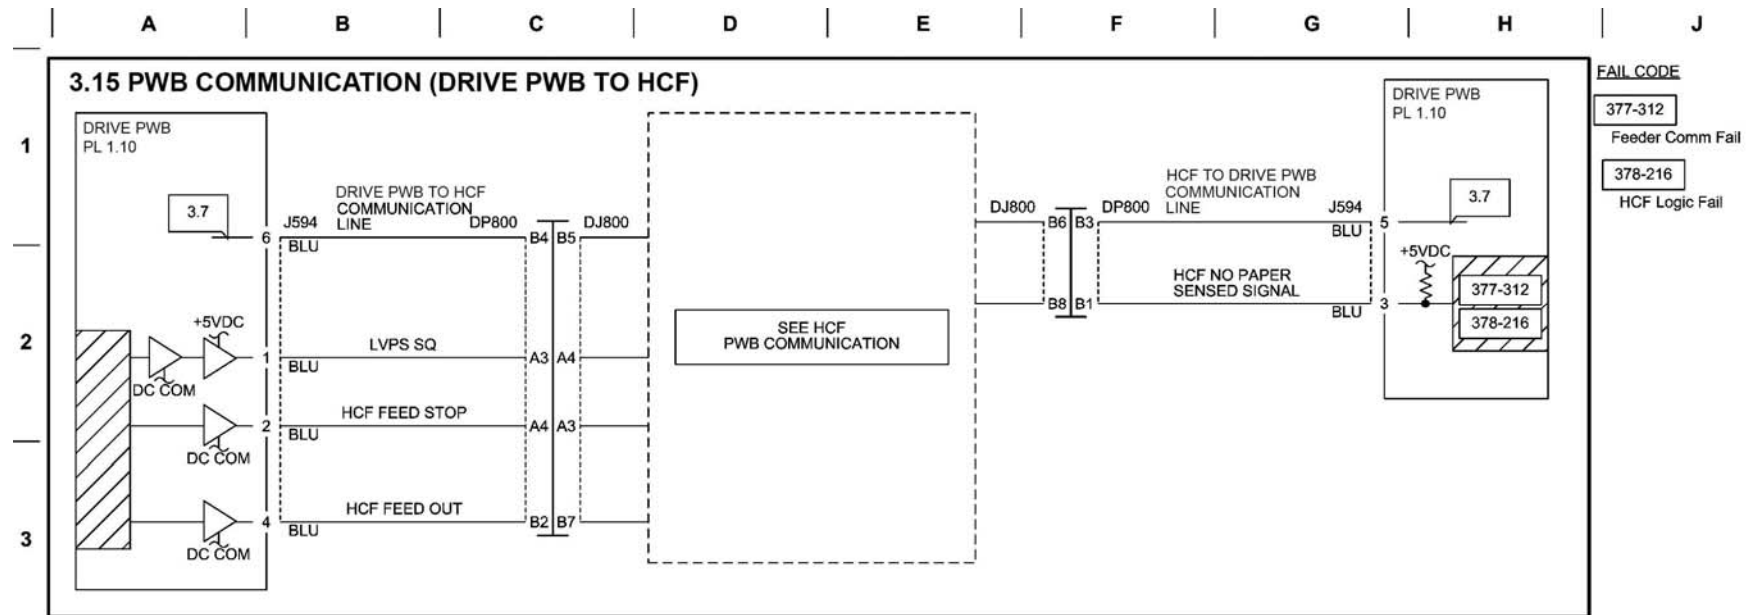
Figure 28 BSD 3.15

BSD 3.15 PWB Communications (Drive PWB to HCF)

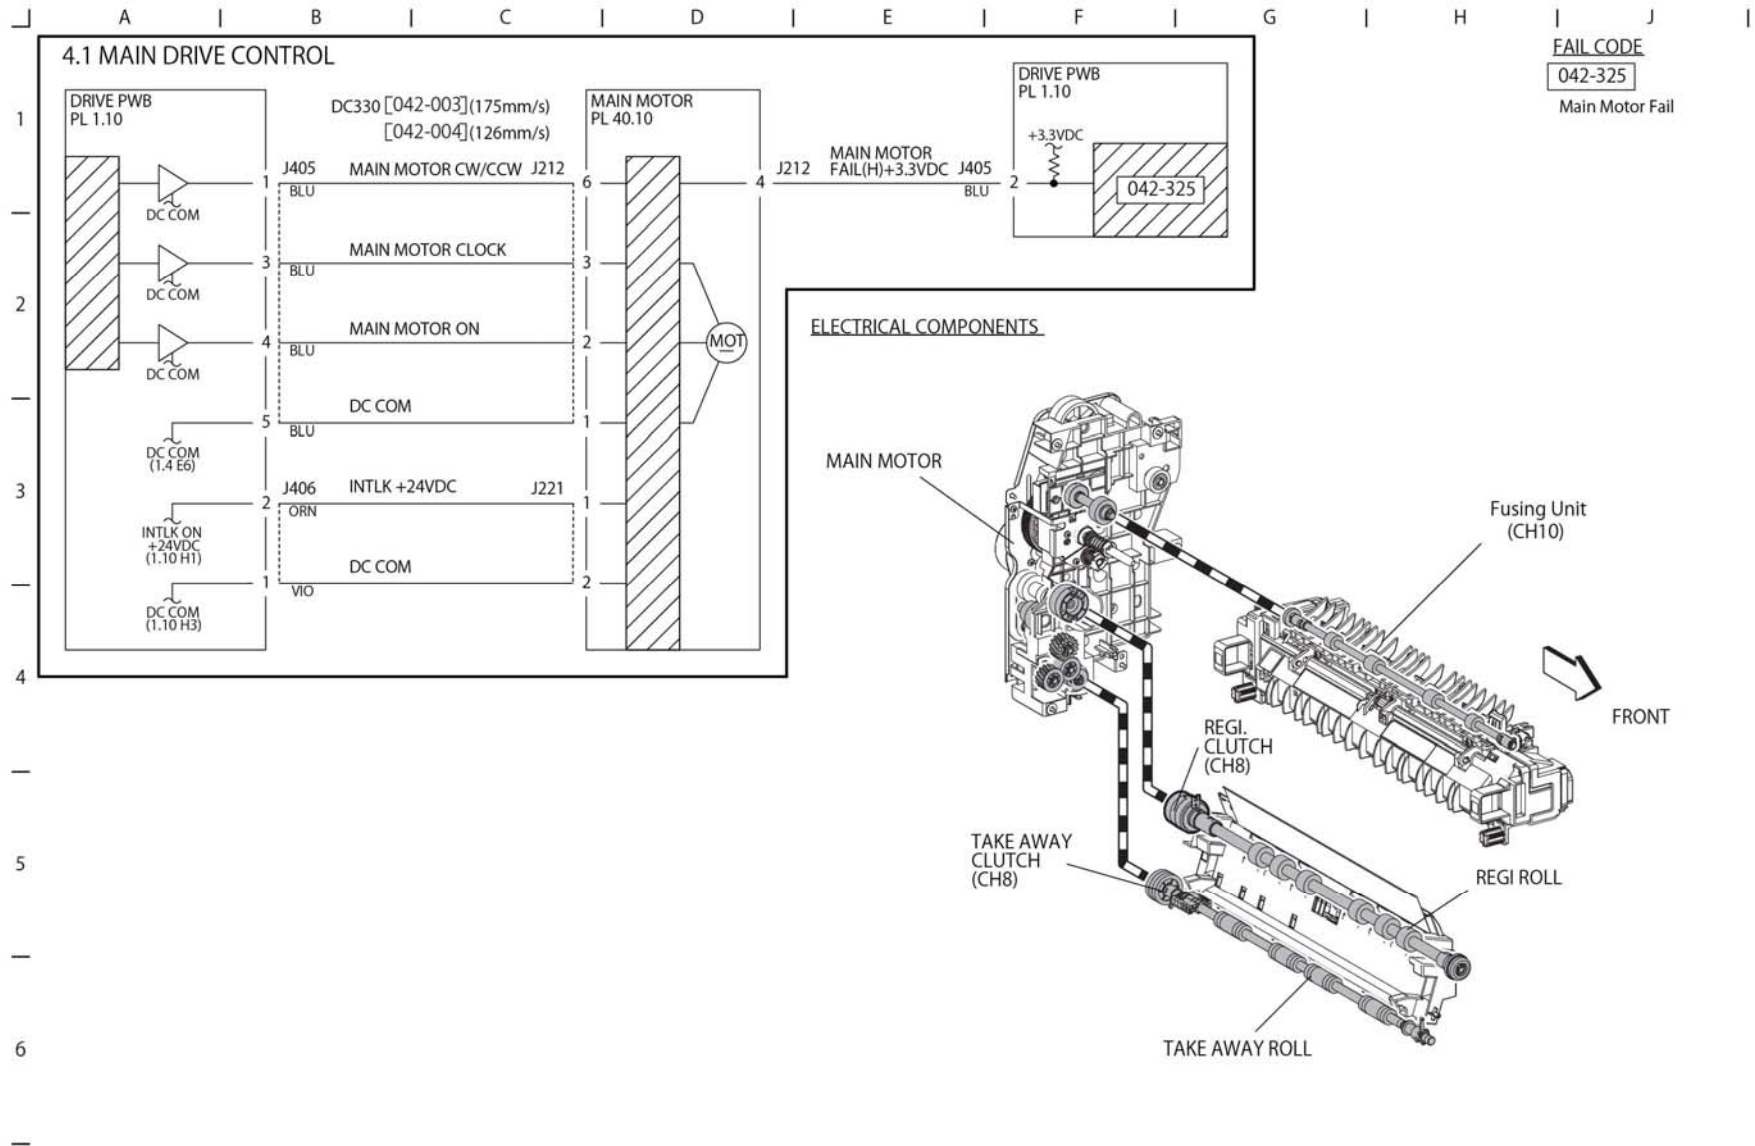
Figure 29 BSD 4.1

BSD 4.1 Main Drive Control

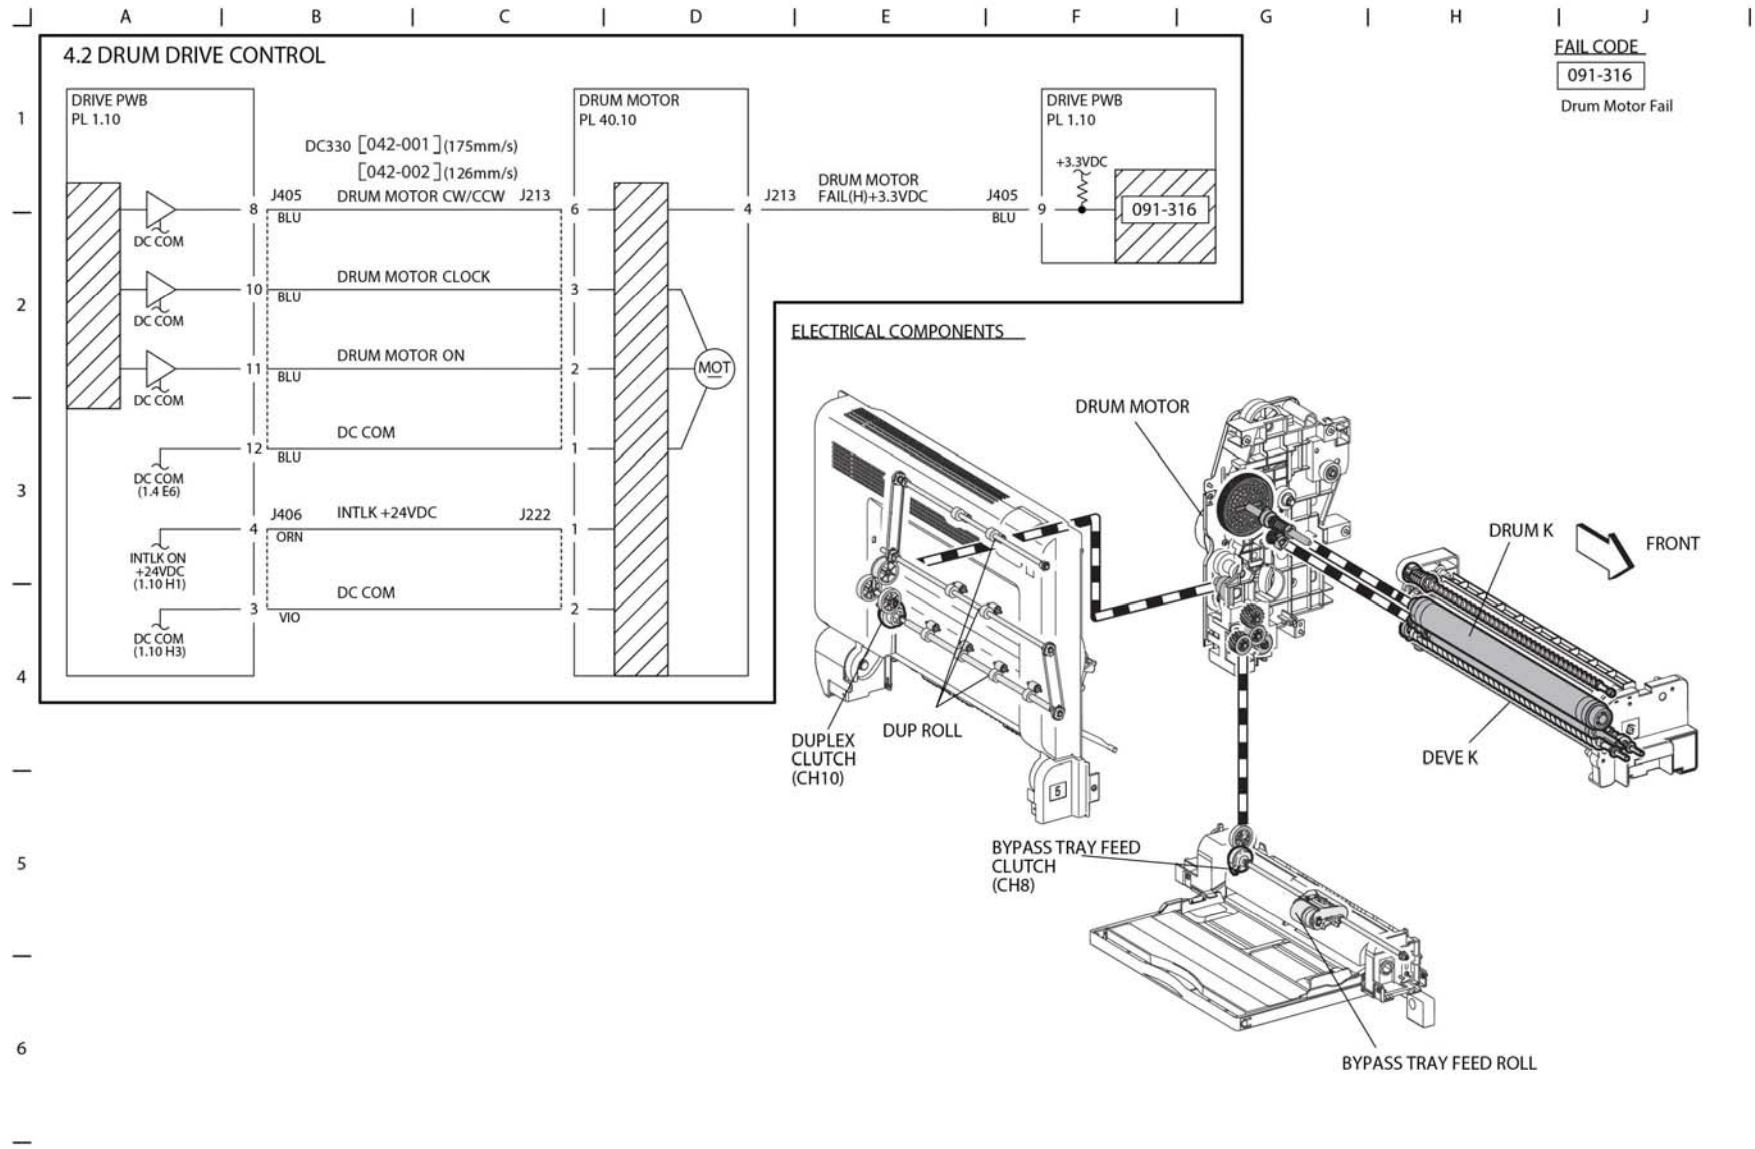
Figure 30 BSD 4.2

BSD 4.2 Drum Drive Control

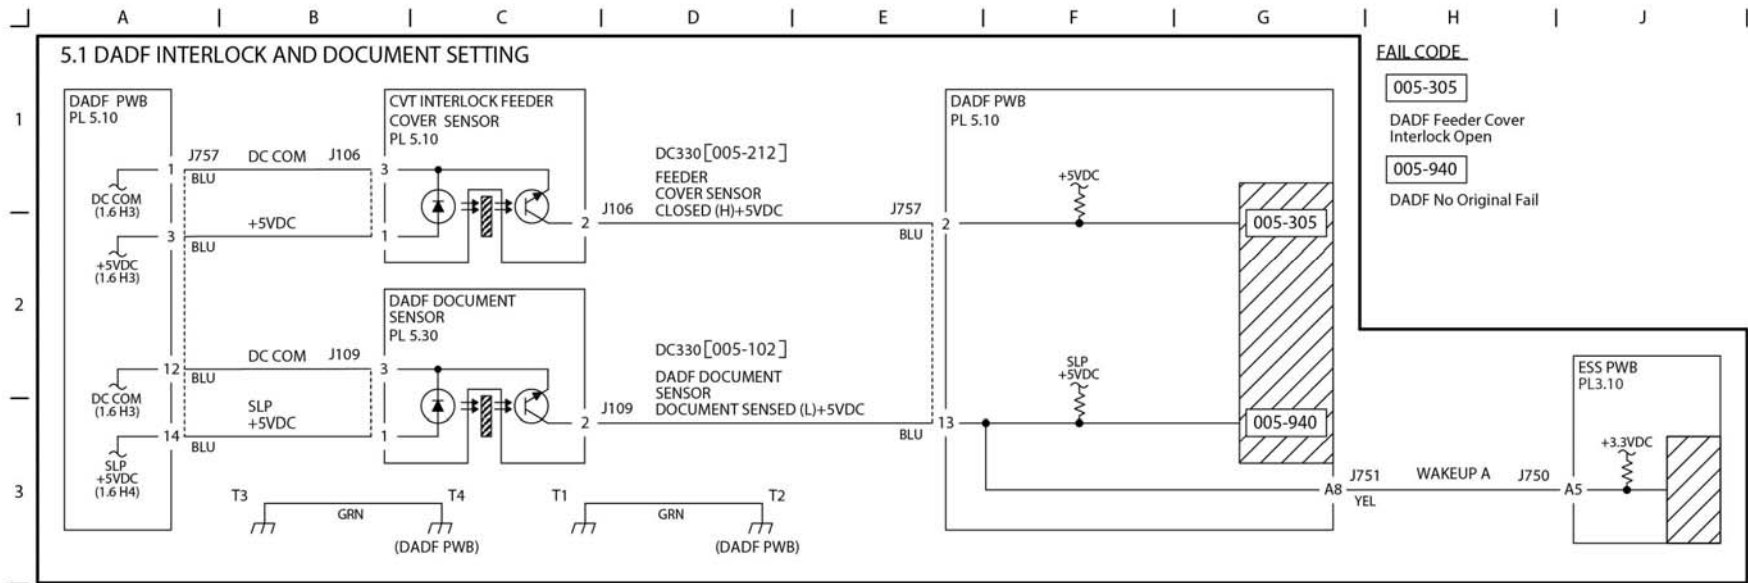
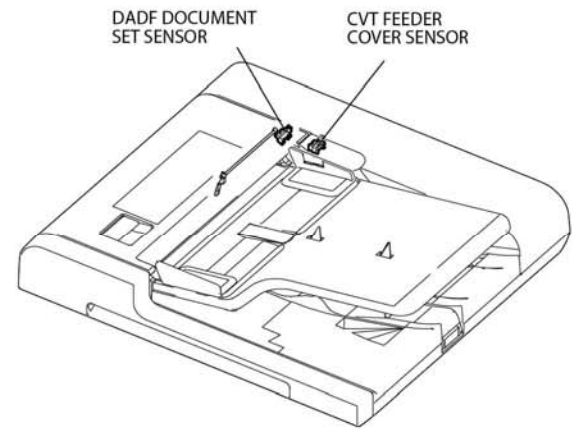
Figure 31 BSD 5.1

BSD 5.1 DADF Interlock and Document Setting

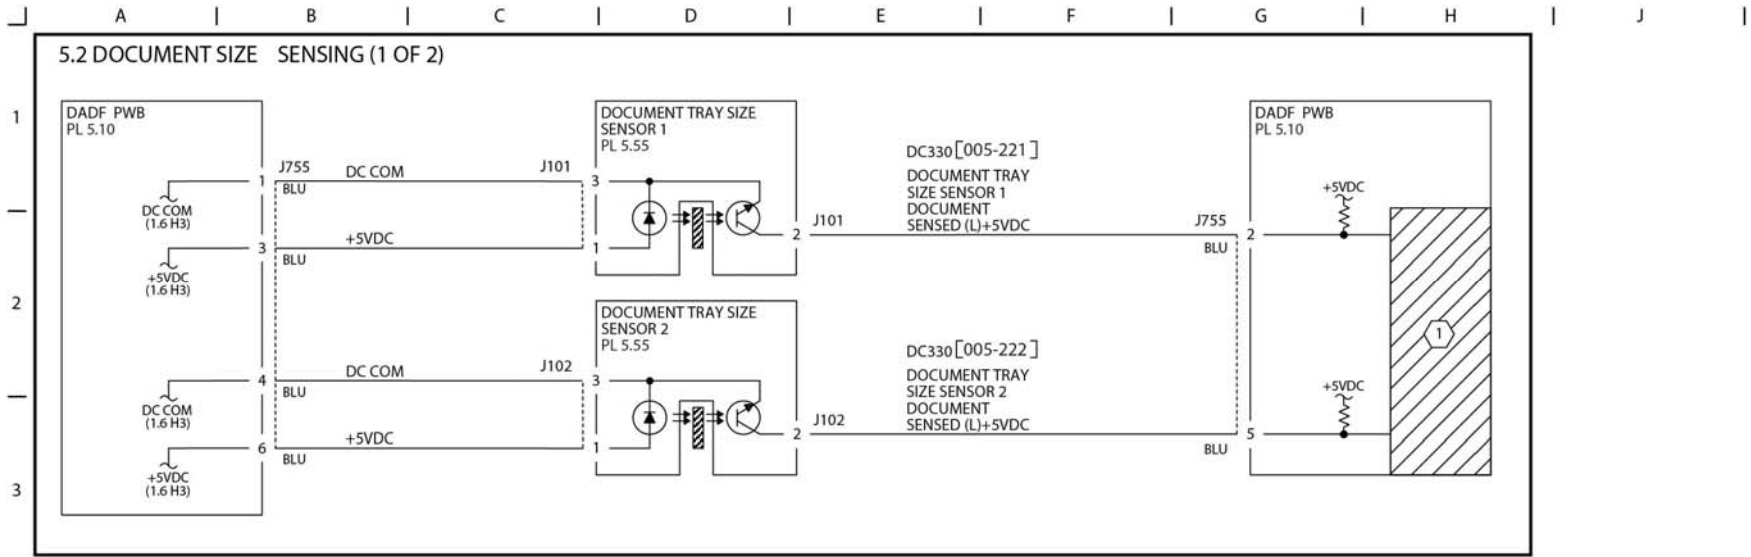
BSD 5.2 DADF Document Size Sensing (1 of 2)

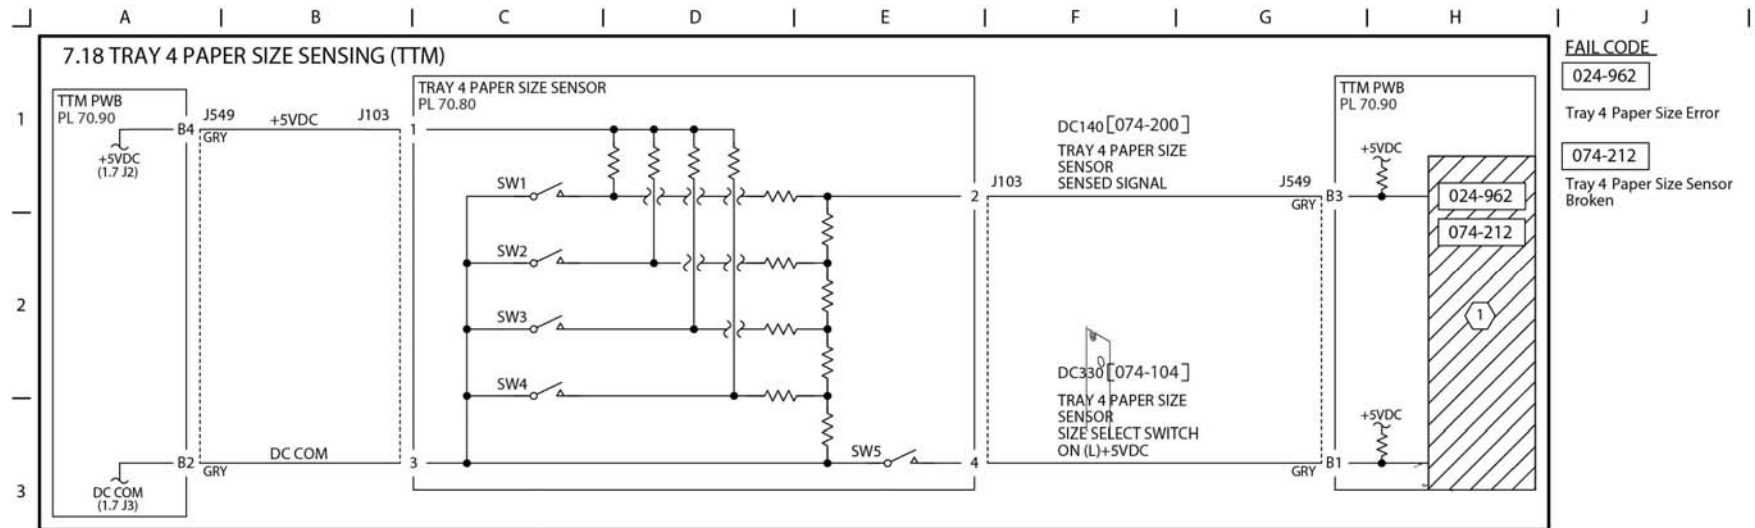
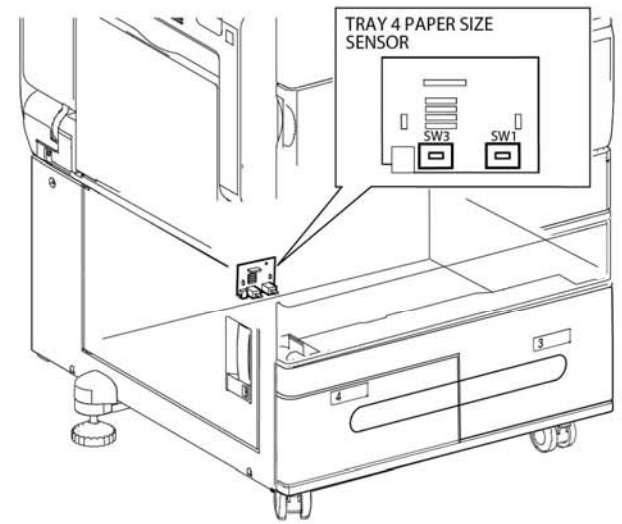
Figure 60 BSD 7.18

BSD 7.18 Tray 4 Paper Size Sensing (TTM)

NOTE: ① Paper size is sensed by voltage corresponding to combined resistance of Paper Size Sensor and SW5 On/Off. The table below shows the relation between paper size and combination of Switch ON/OFF pattern, voltage and AD value. (Any combination other than the ones below results in an undetermined size.)

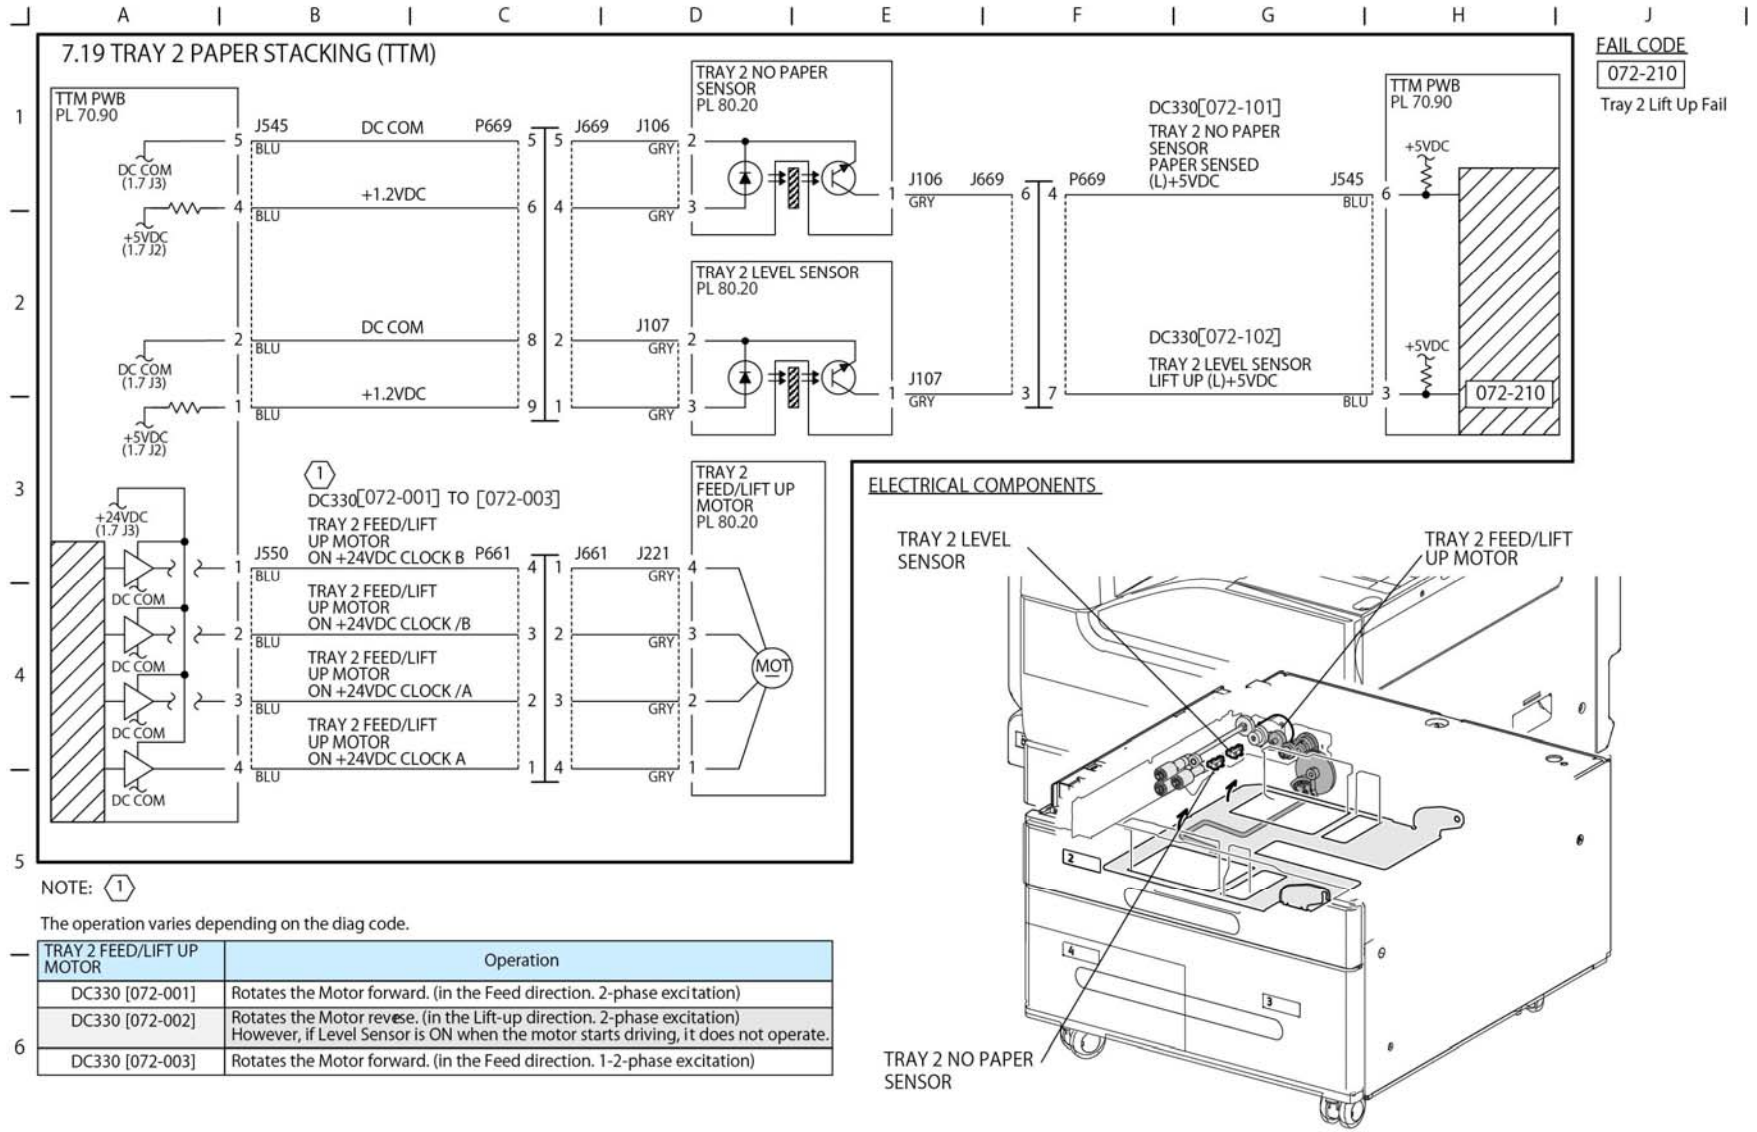
Figure 61 BSD 7.19

BSD 7.19 Tray 2 Paper Stacking (TTM)

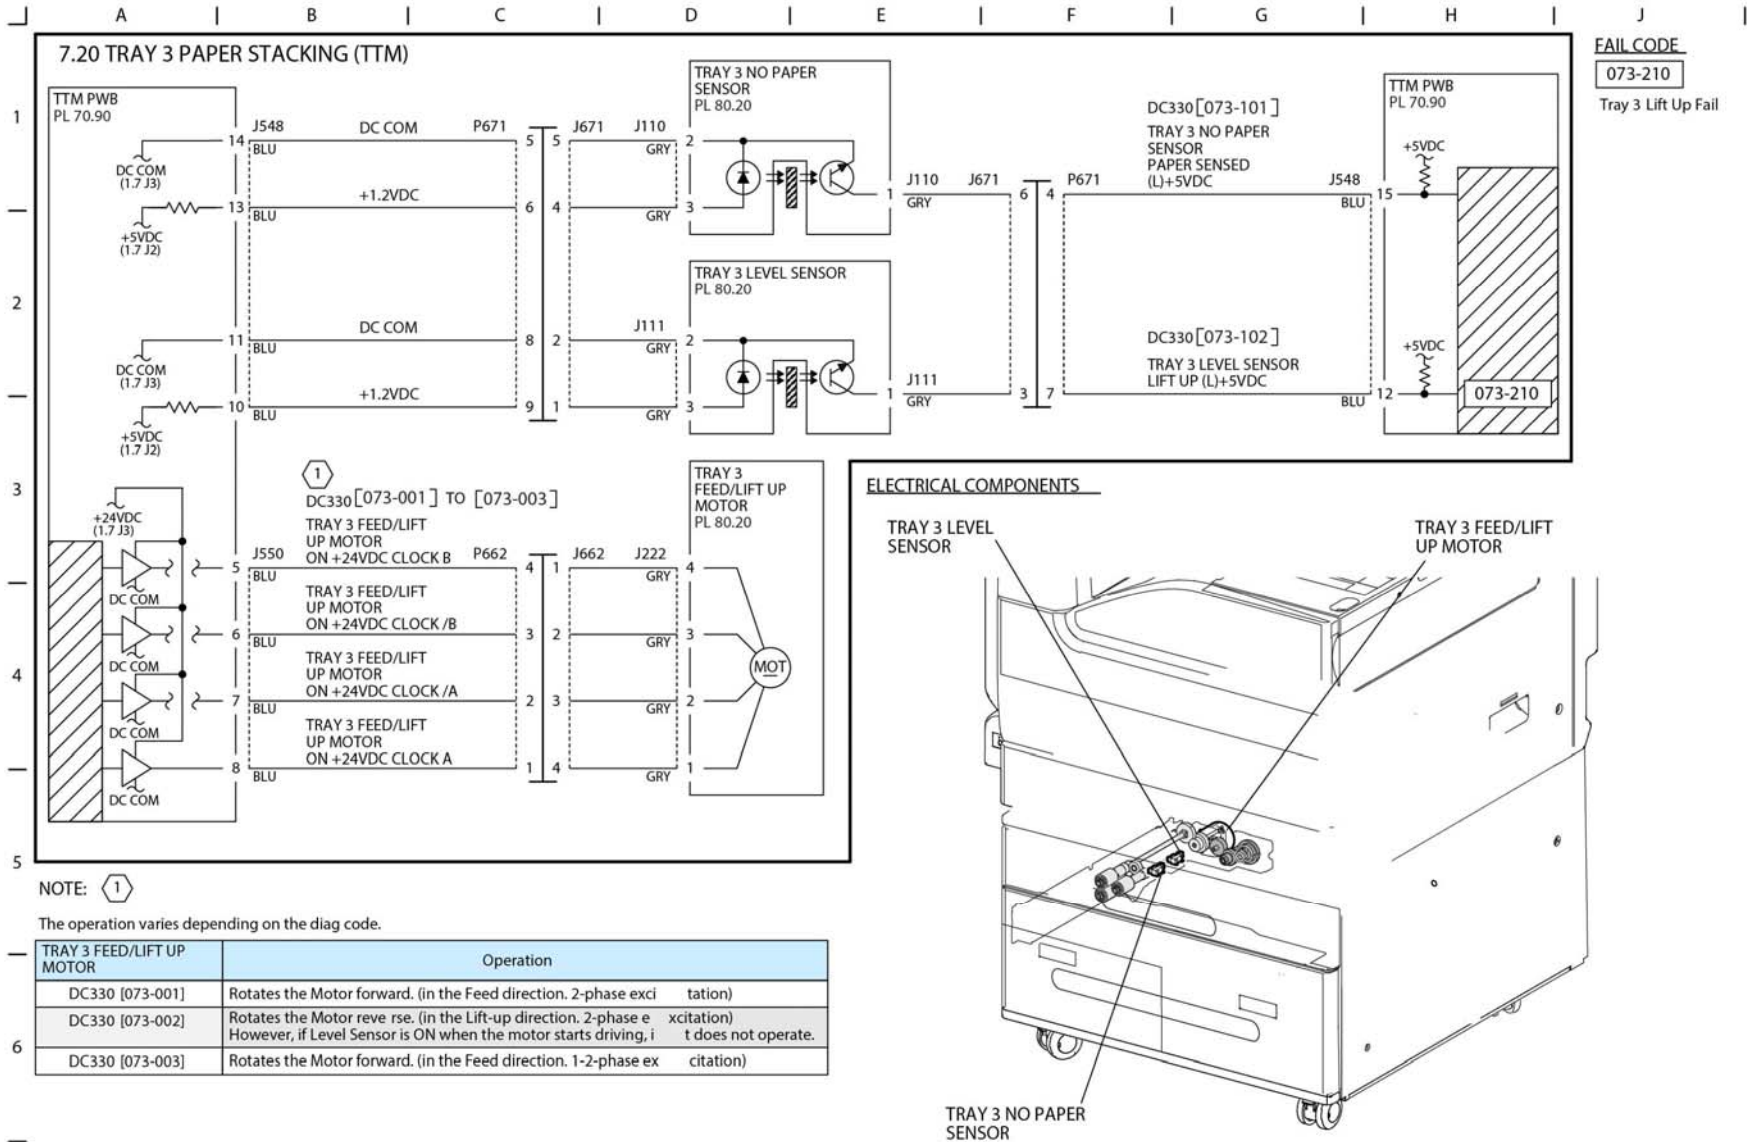
Figure 62 BSD 7.20

BSD 7.20 Tray 3 Paper Stacking (TTM)

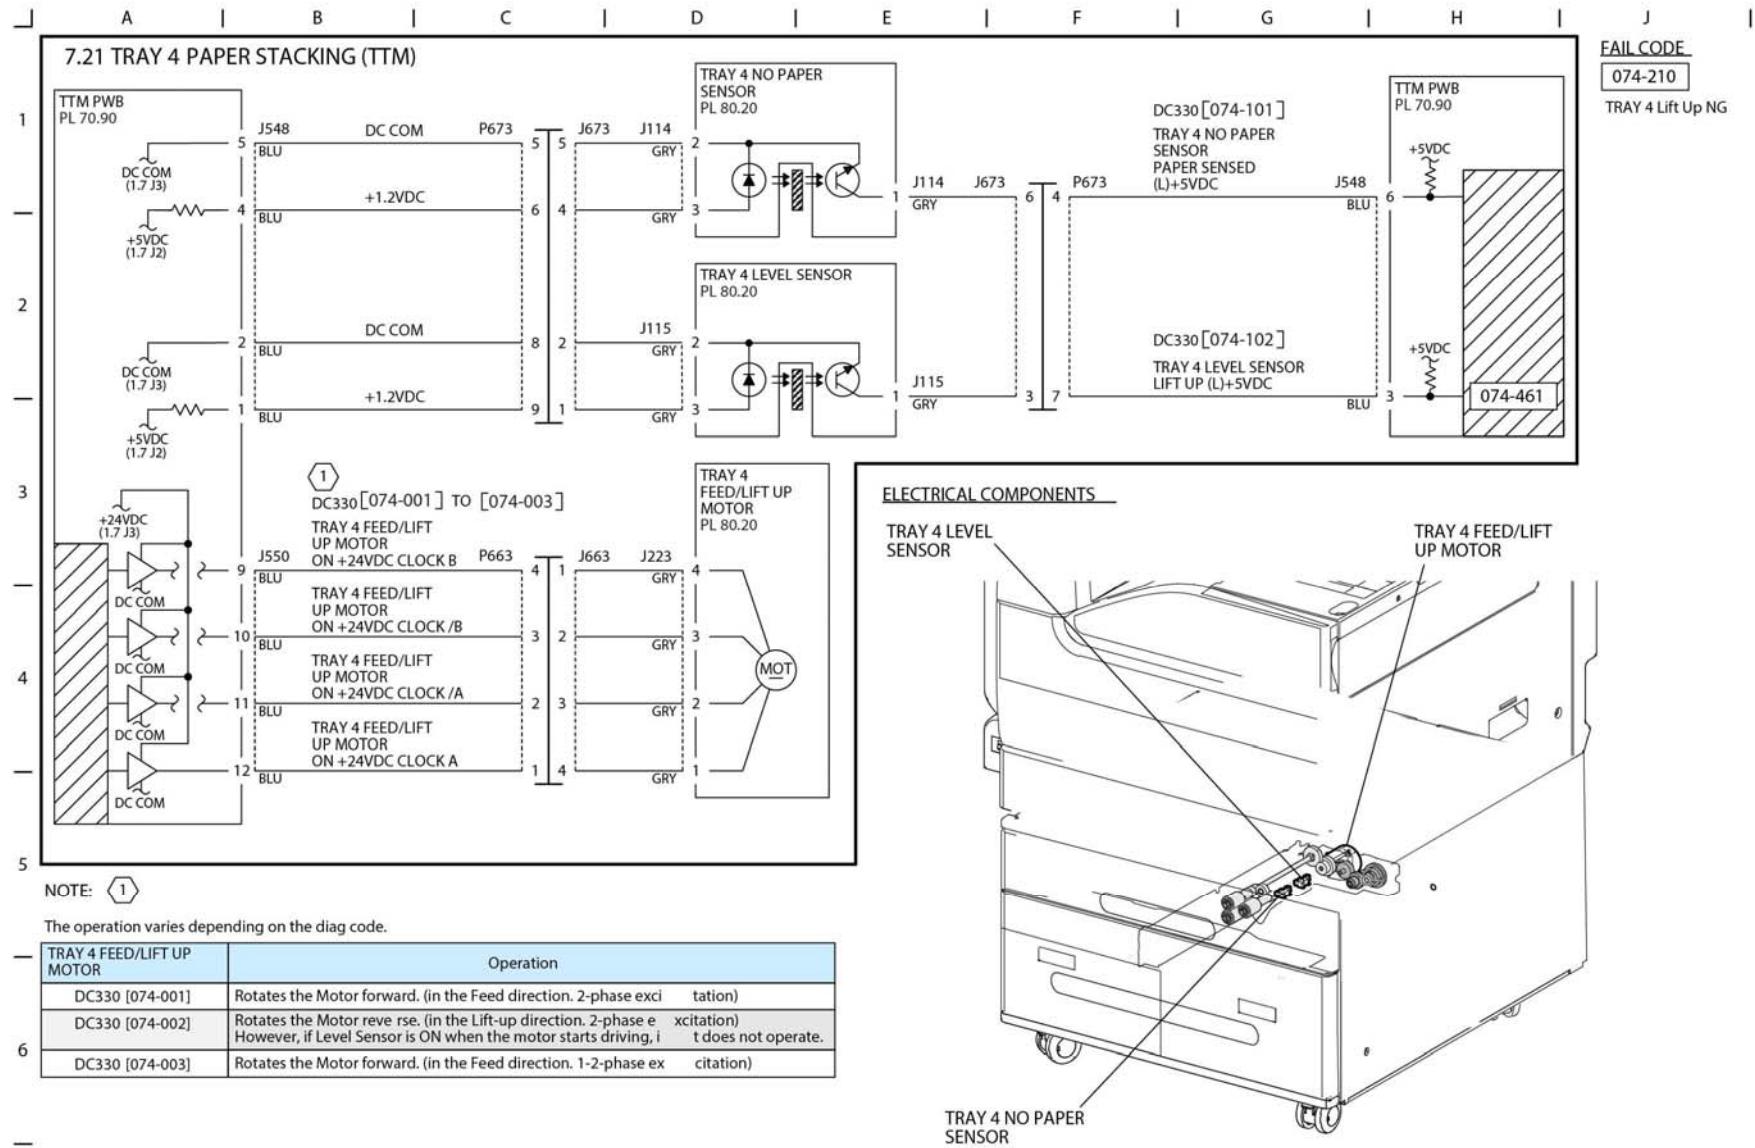
Figure 63 BSD 7.21

BSD 7.21 Tray 4 Paper Stacking (TTM)

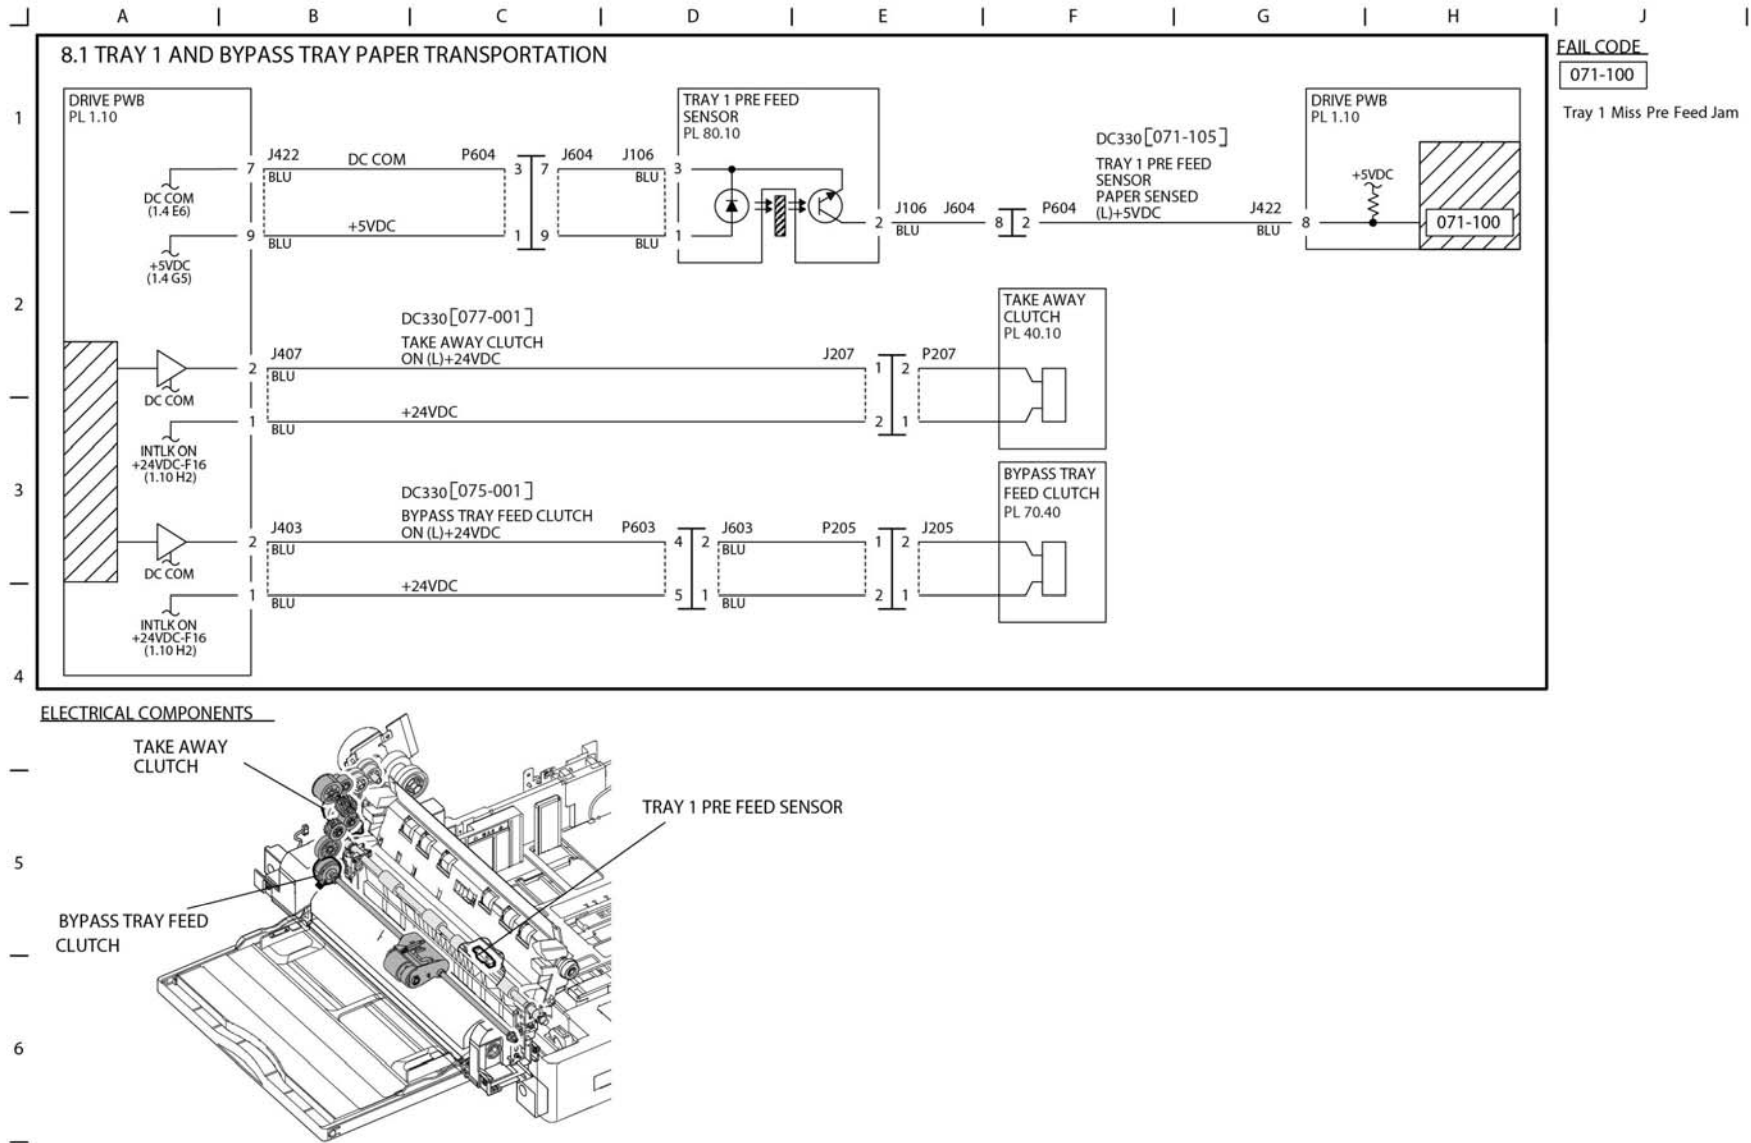
Figure 64 BSD 8.1

BSD 8.1 Tray 1 and Bypass Tray Paper Transportation

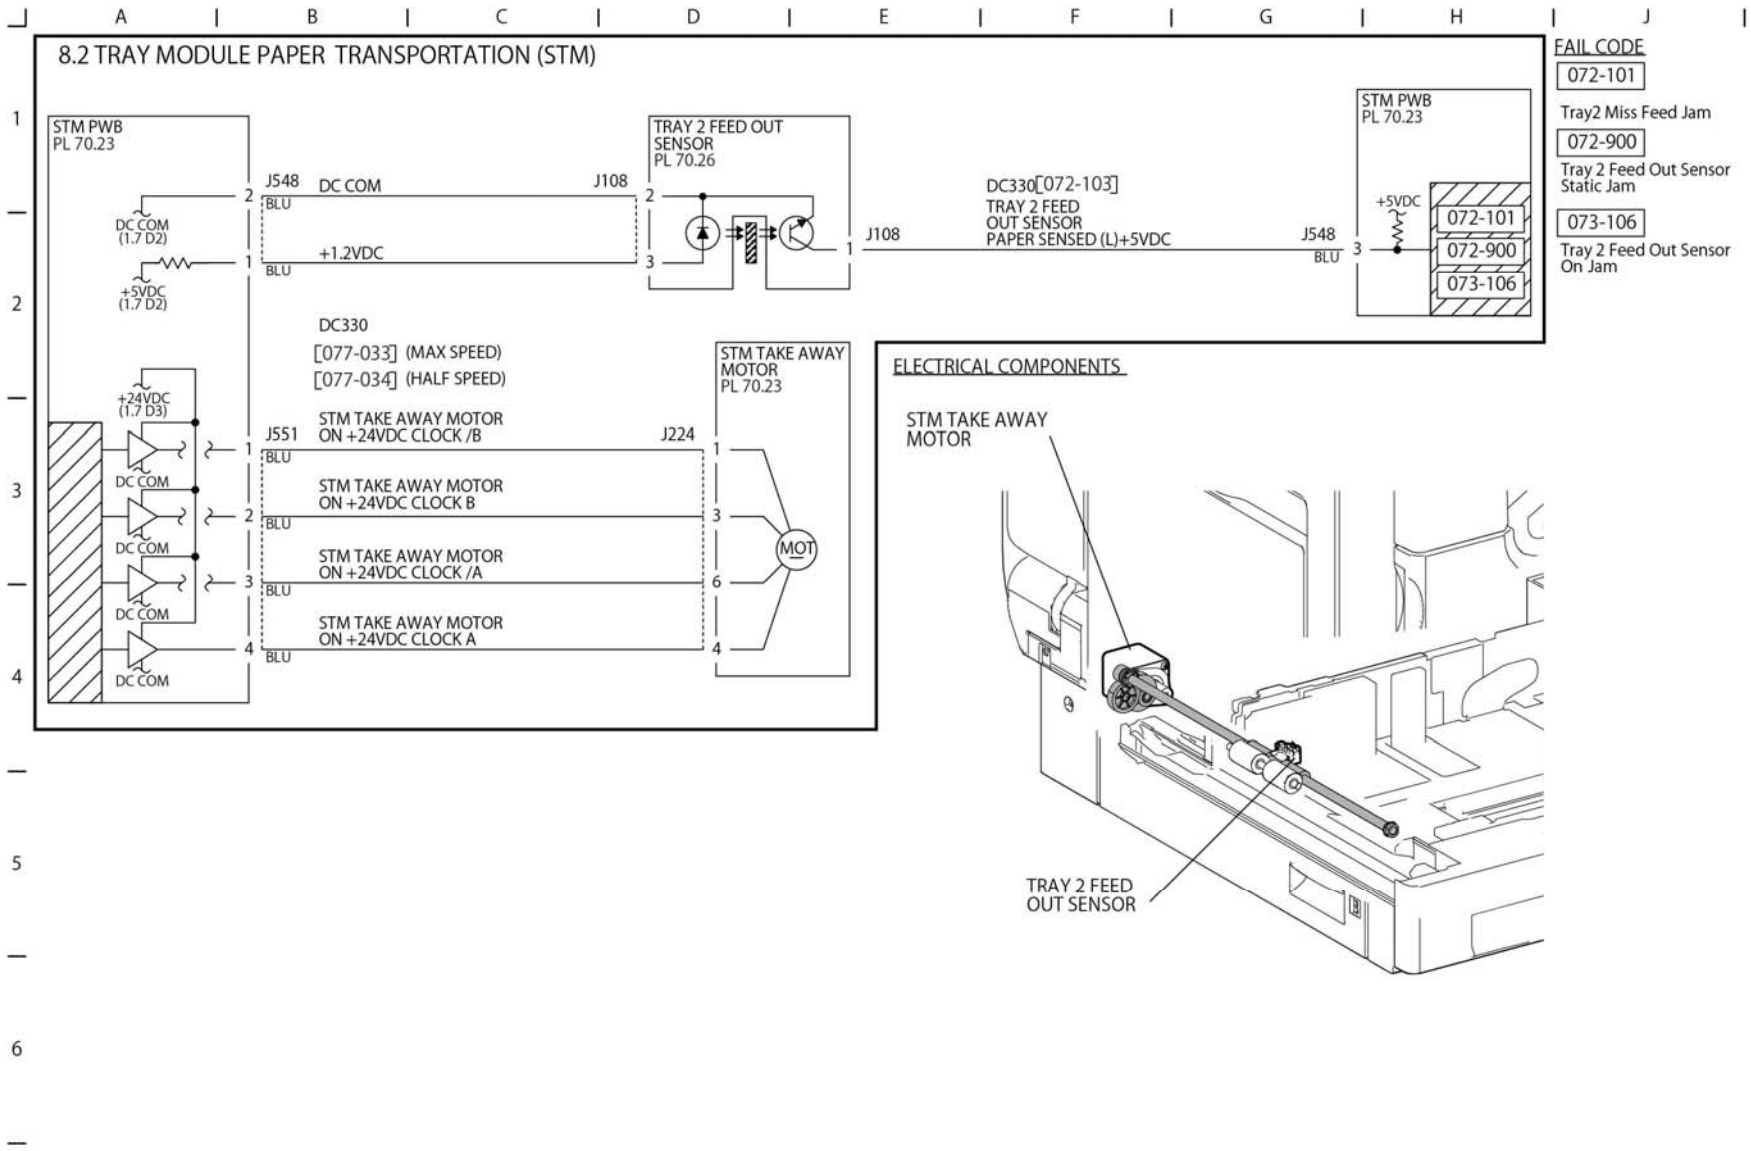
Figure 65 BSD 8.2

BSD 8.2 Tray Module Paper Transportation (STM)

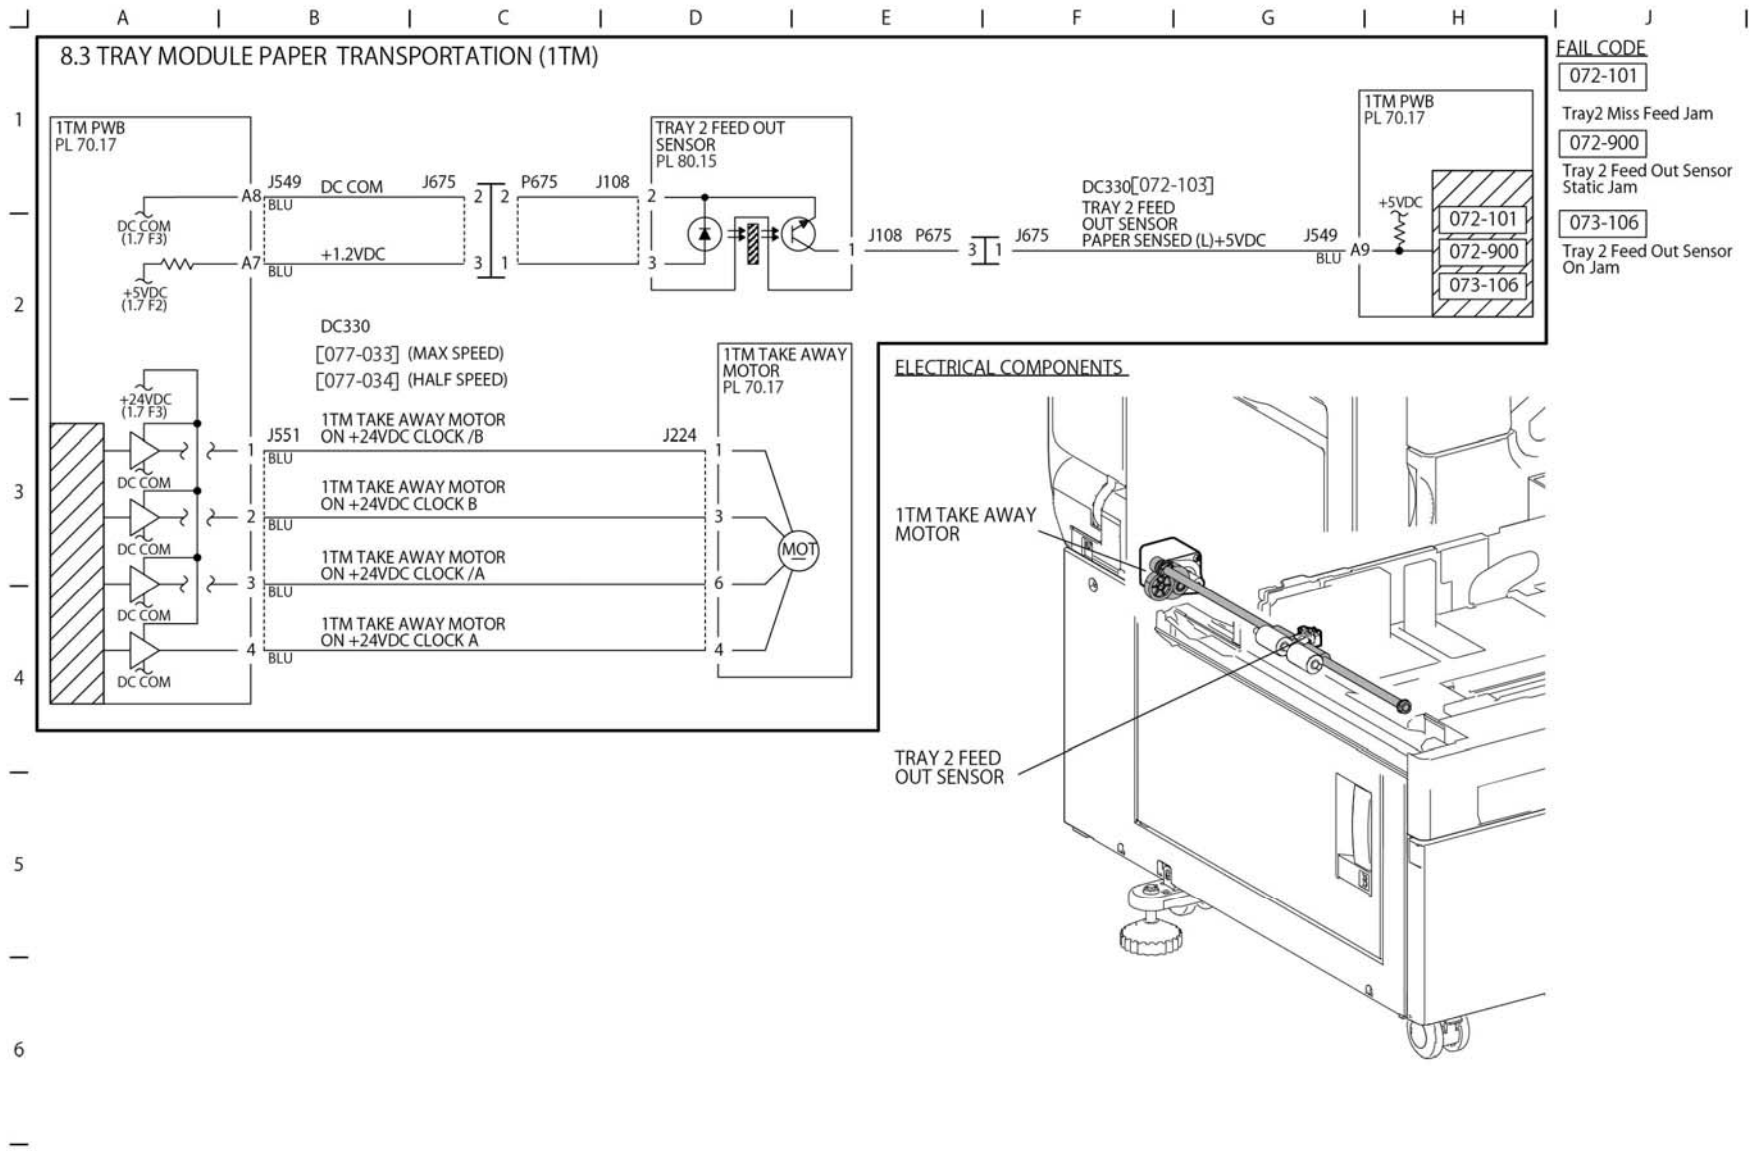
Figure 66 BSD 8.3

BSD 8.3 Tray Module Paper Transportation (1TM)
