708P91370
April 2017

Xerox® VersaLink® B7025/B7030/B7035 Multifunction Printer Service Manual

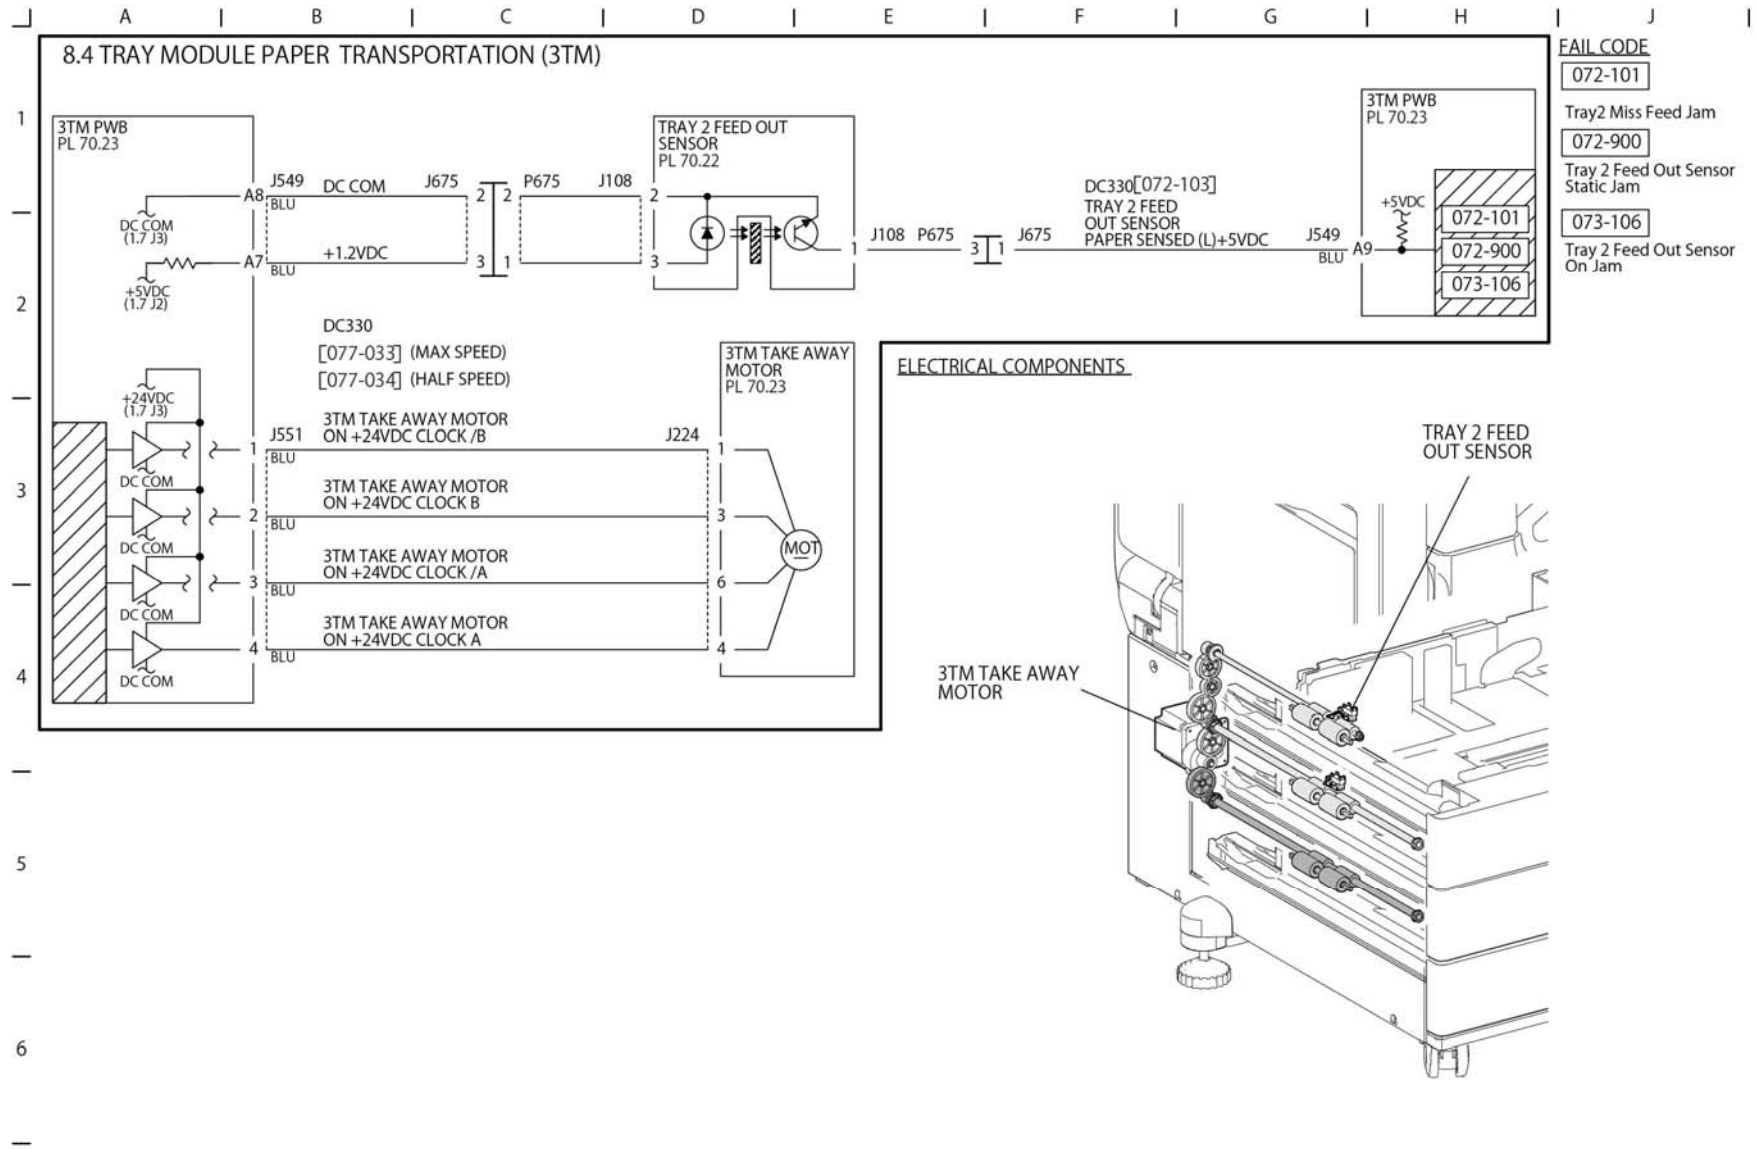
Figure 67 BSD 8.4

BSD 8.4 Tray Module Paper Transportation (3TM)

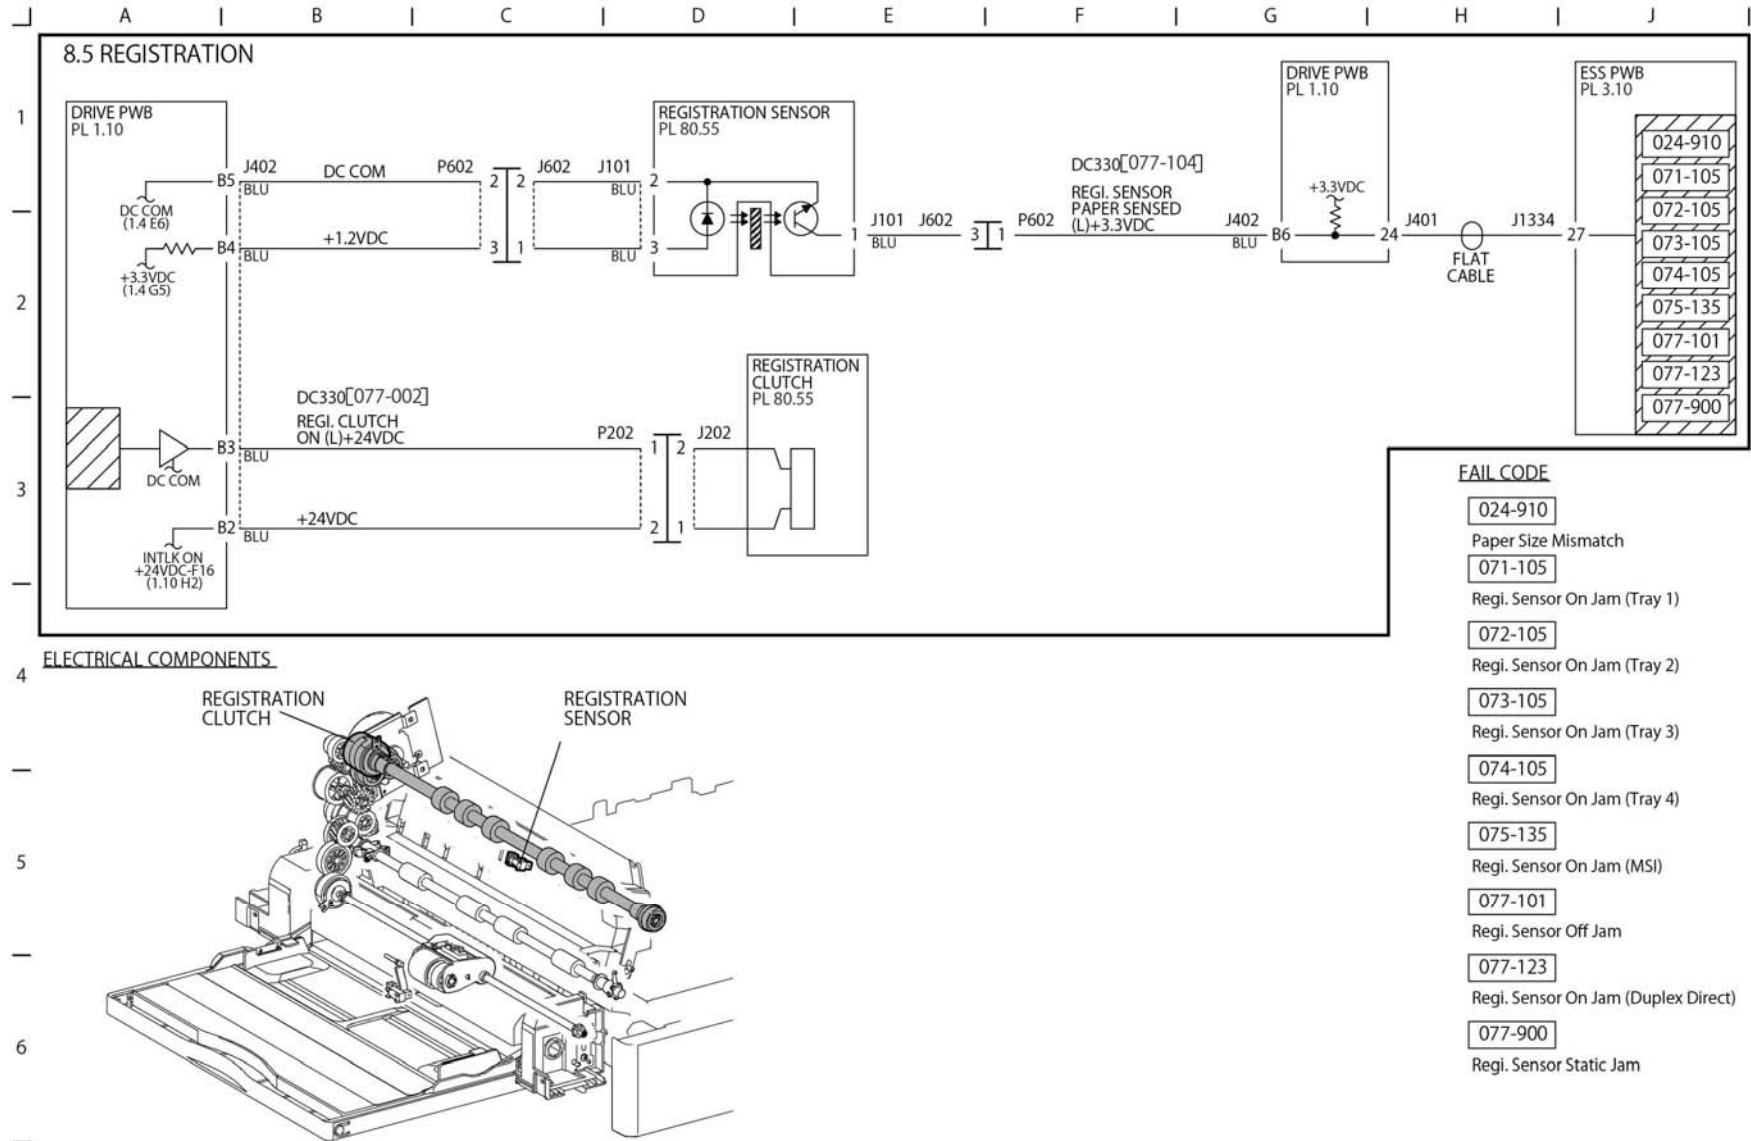
Figure 68 BSD 8.5

BSD 8.5 Registration

The registration sensor detects the paper just prior to the registration nip rolls. Its signal, in conjunction with the registration clutch on signal, indicates media jams, i.e., if the registration clutch on signal has occurred and the sensor fails to stay on a specified time, a jam downstream from the sensor or in the duplex path is indicated and the paper path transport system will shut down. The control logic also uses the signal from the registration sensor (registration sensor off) in the control of duplex transport operations, bypass feed start timing, and tray 1 feed start timing, [Figure 9](#).

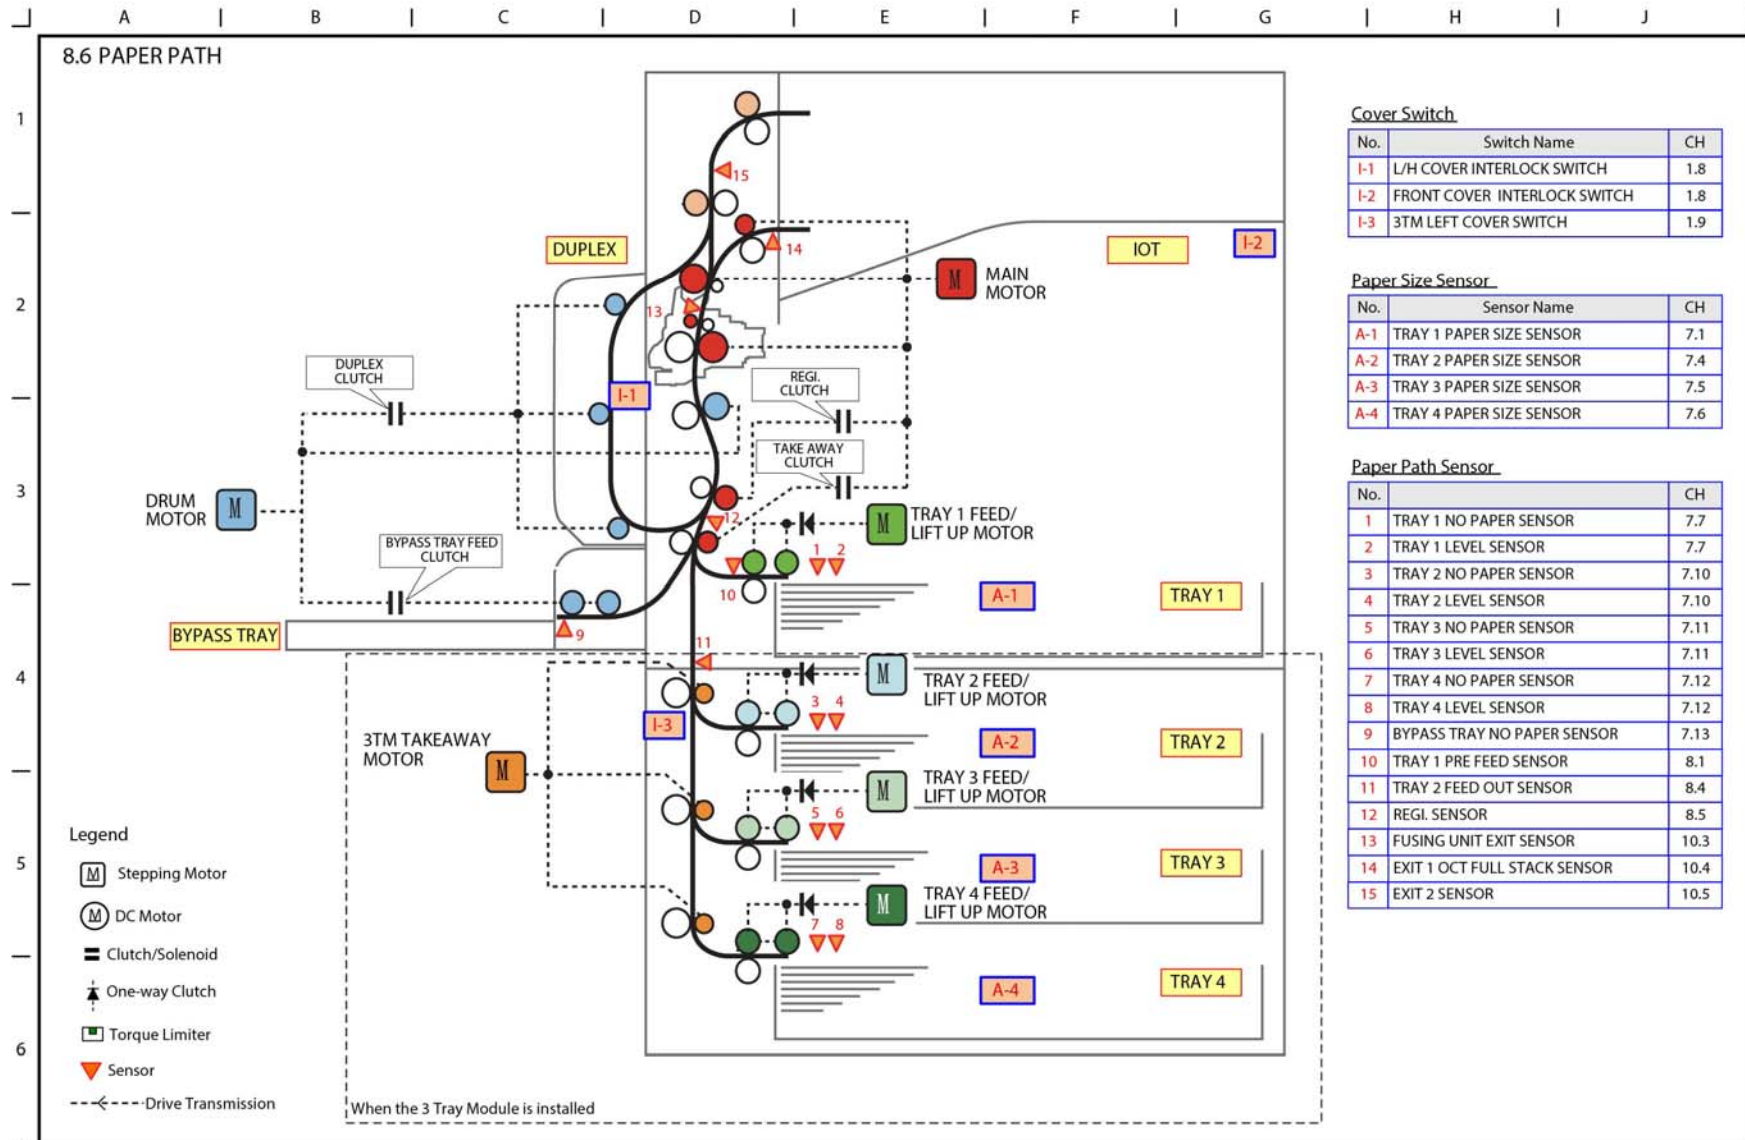
Figure 69 BSD 8.6

BSD 8.6 Paper Path

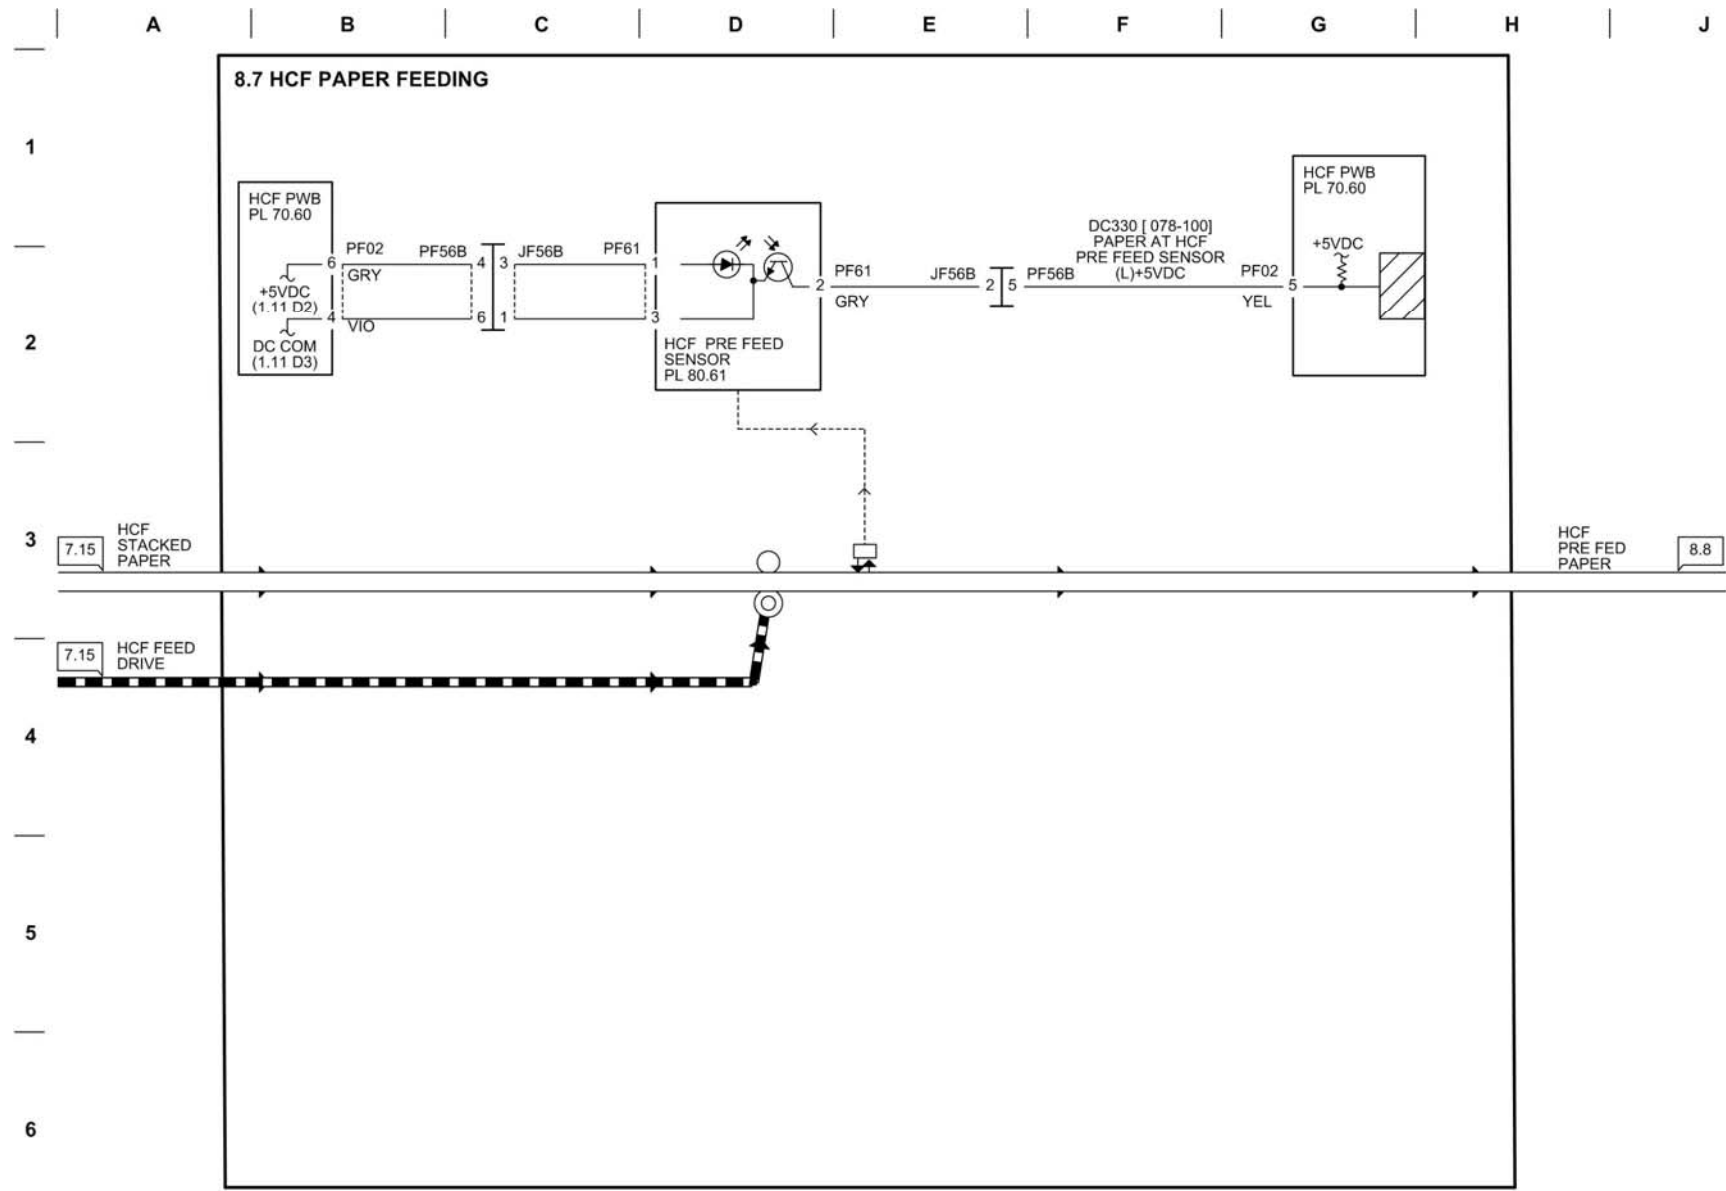
Figure 70 BSD 8.7

BSD 8.7 HCF Paper Feeding

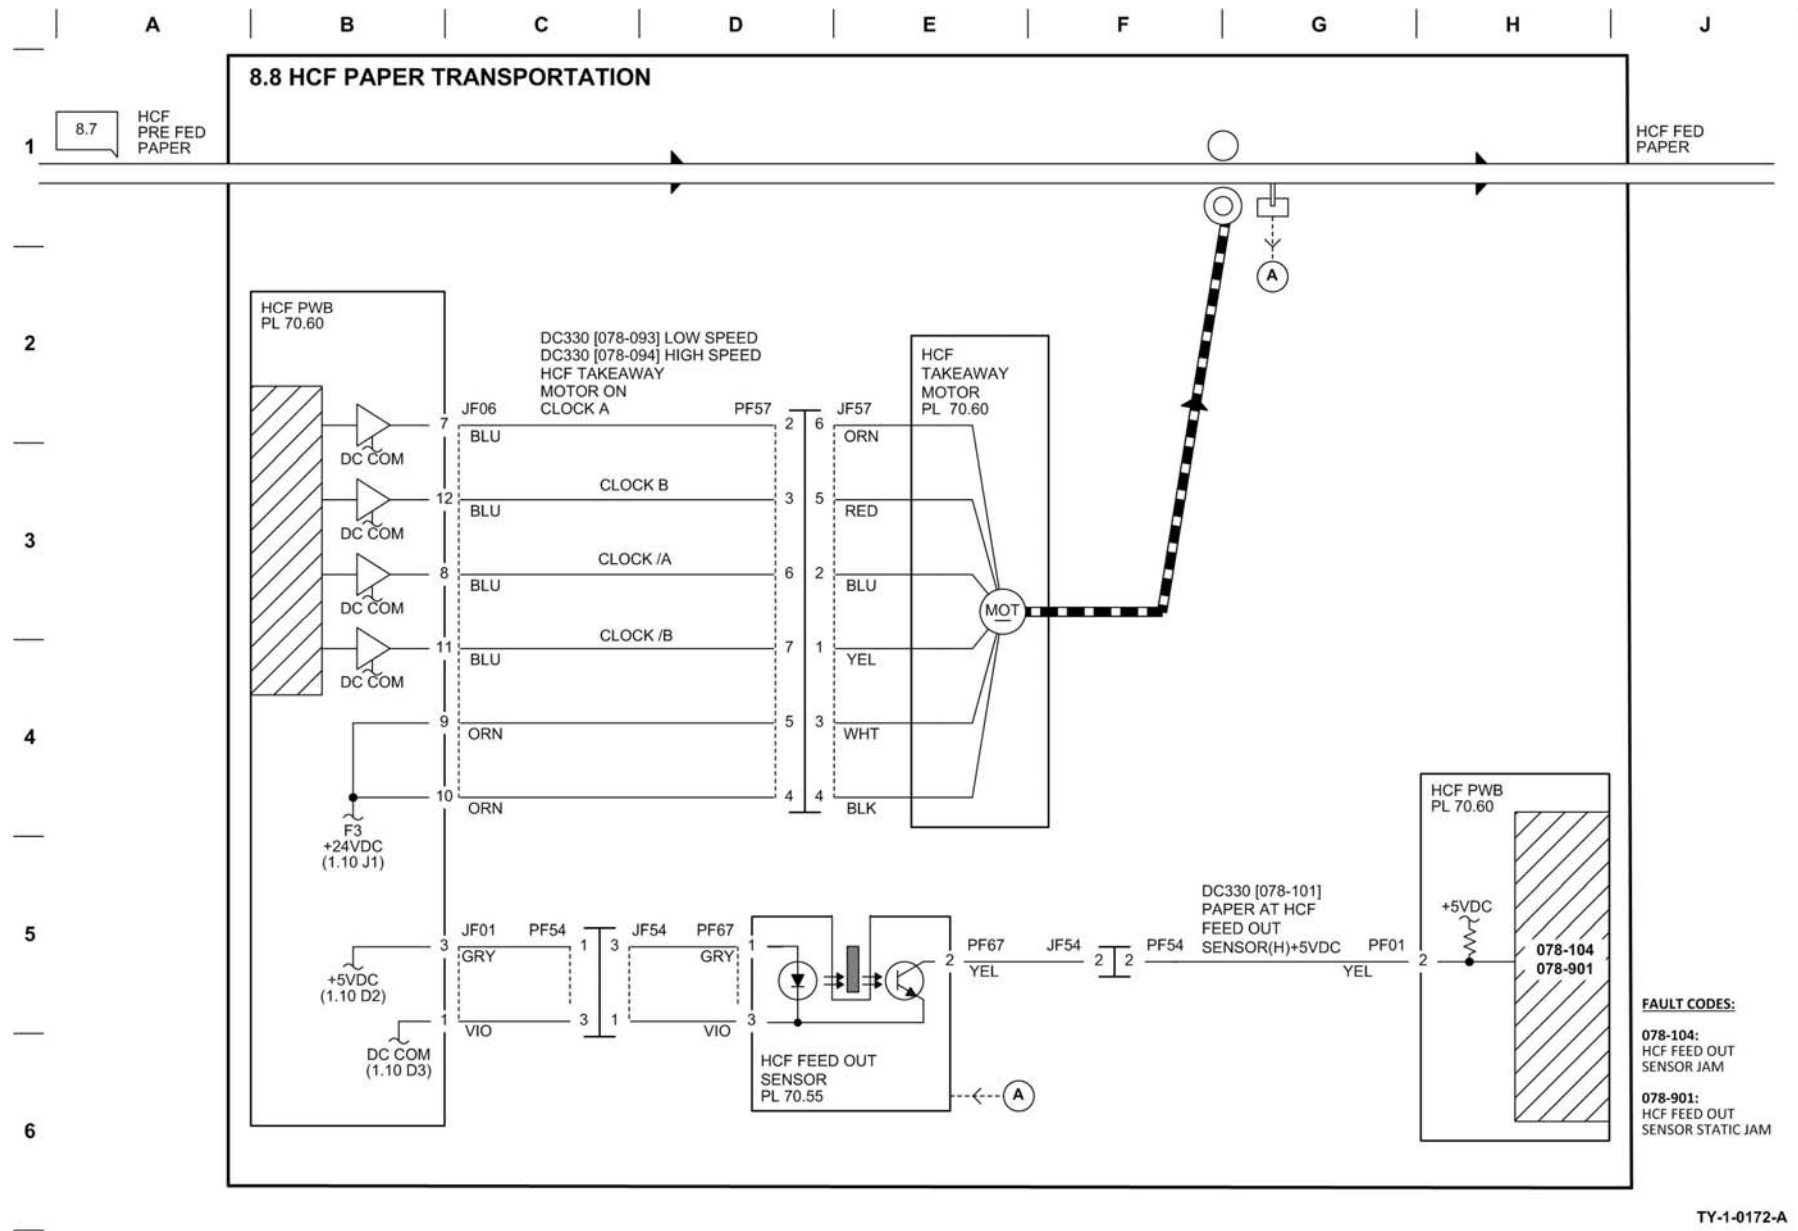
Figure 71 BSD 8.8

BSD 8.8 HCF Paper Transportation

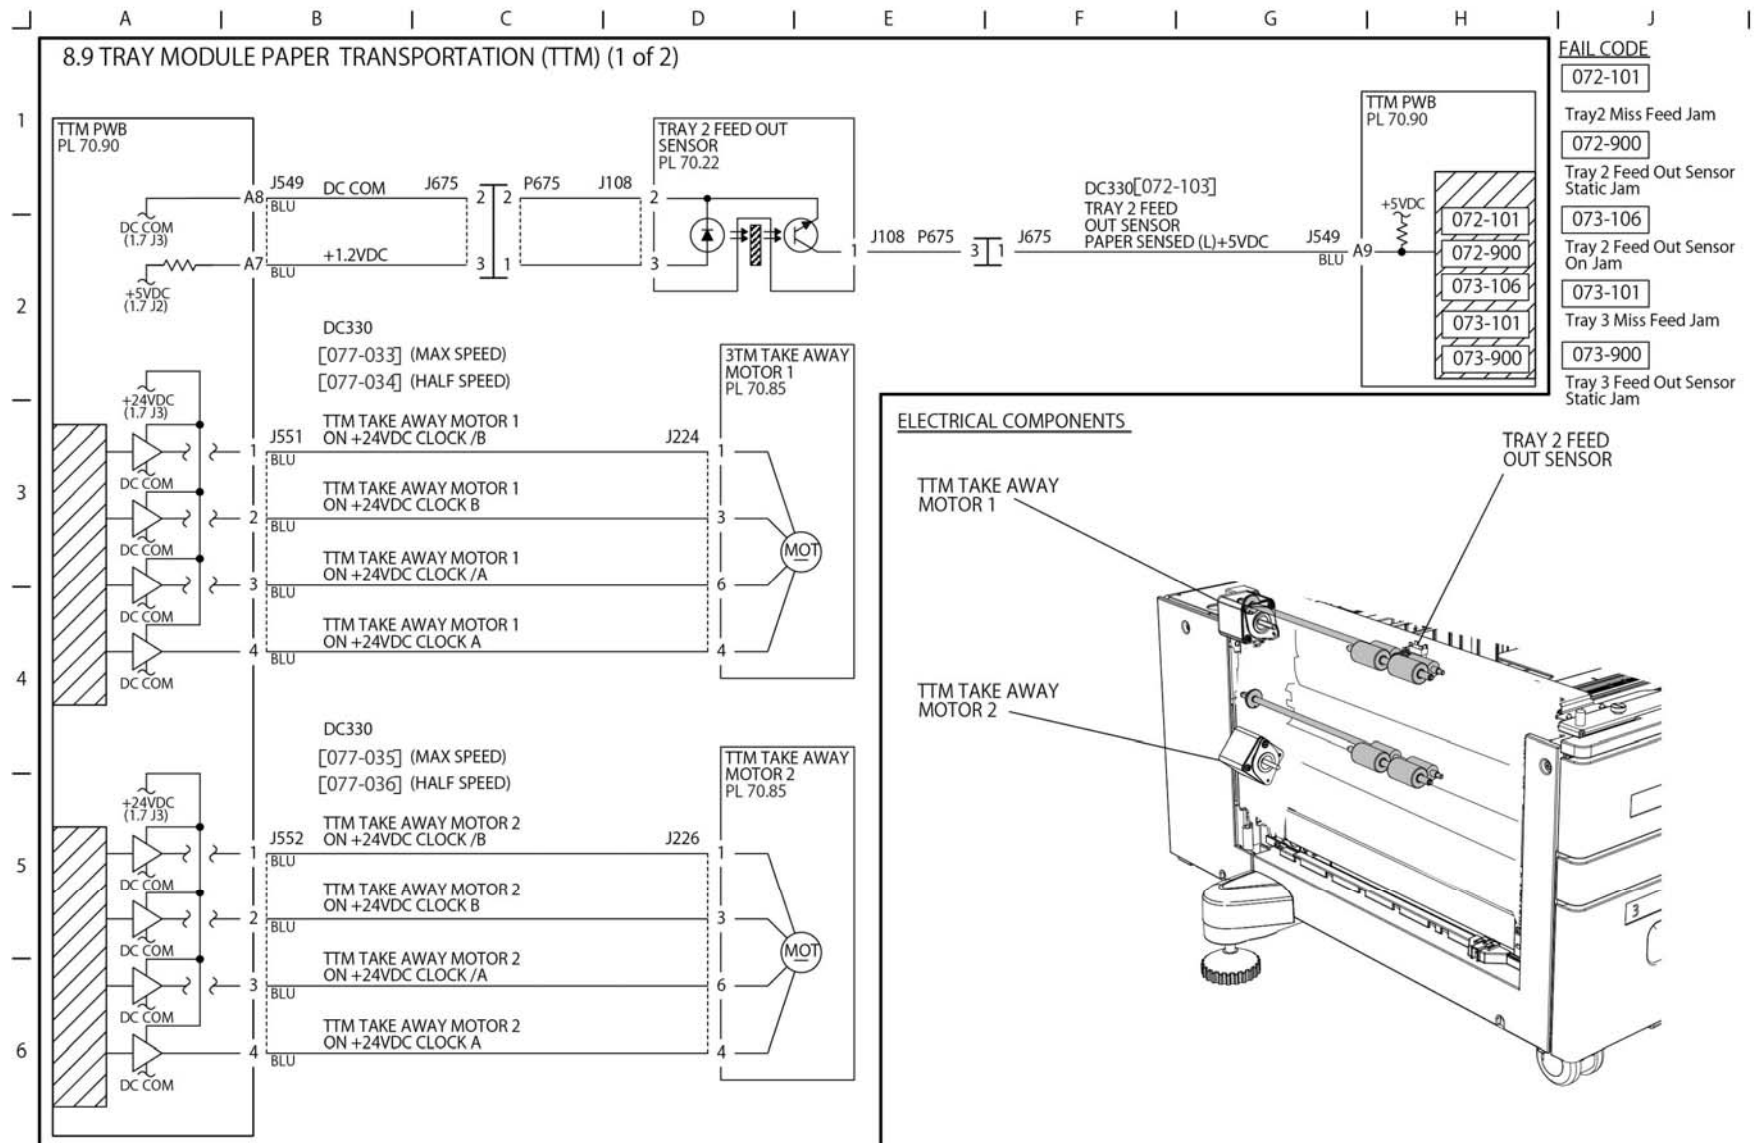
Figure 72 BSD 8.9

BSD 8.9 Tray Module Paper Transportation (TTM) (1 of 2)

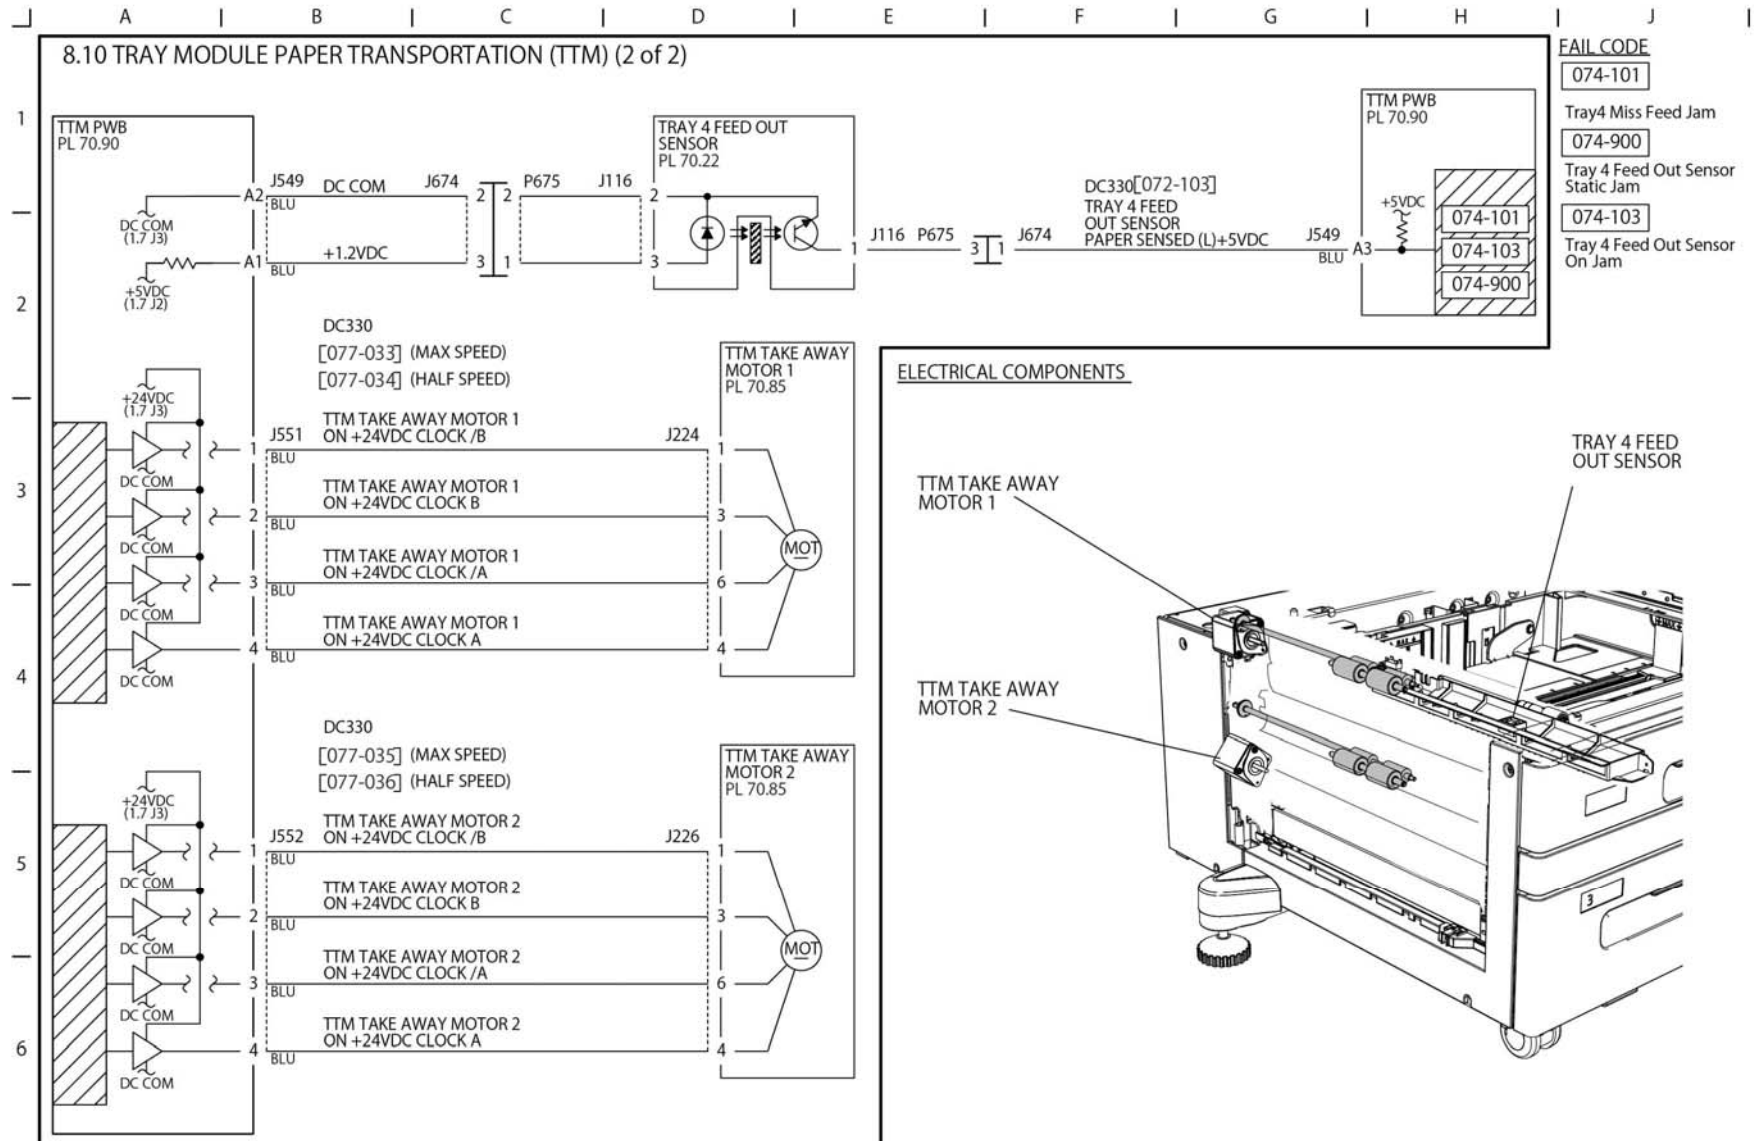
Figure 73 BSD 8.10

BSD 8.10 Tray Module Paper Transportation (TTM) (2 of 2)

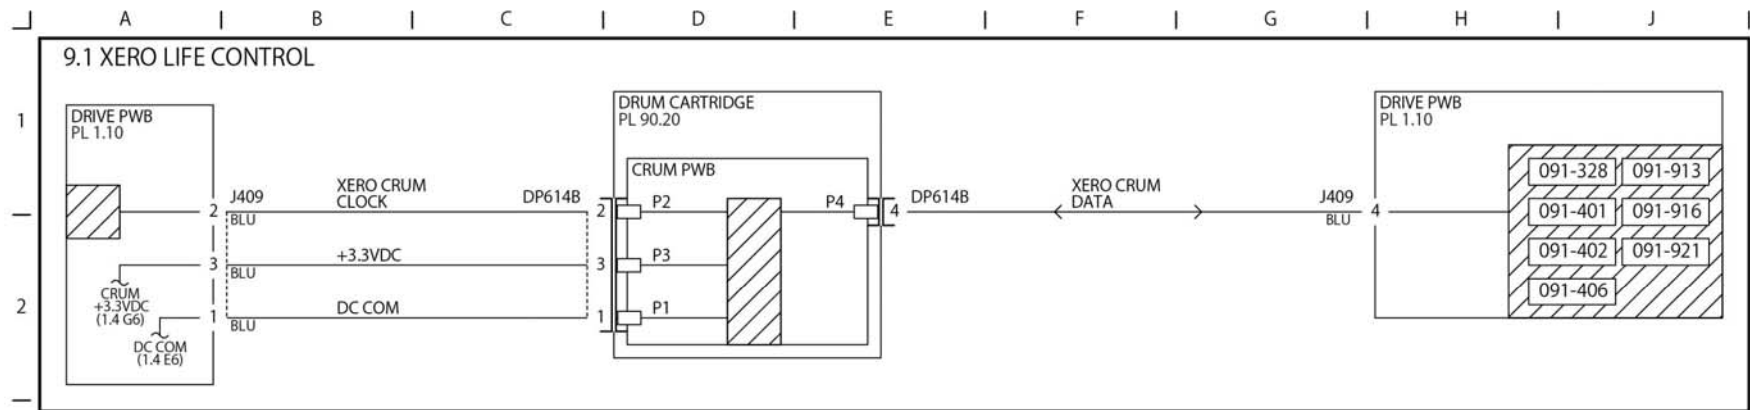
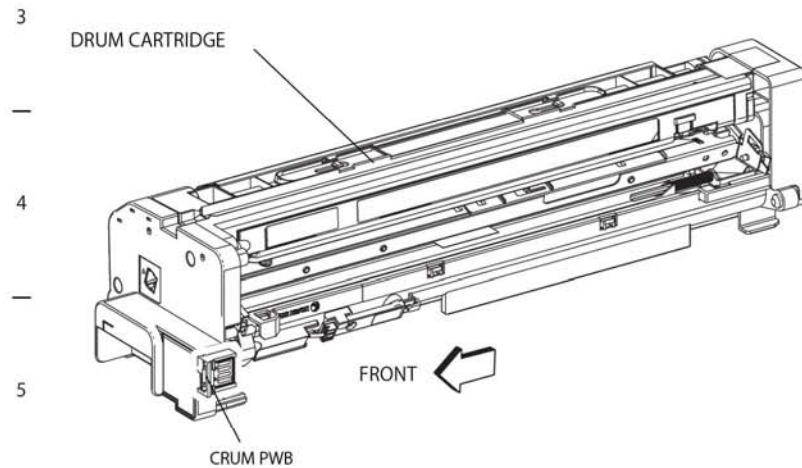
Figure 74 BSD 9.1

BSD 9.1 Xerographic Life Control

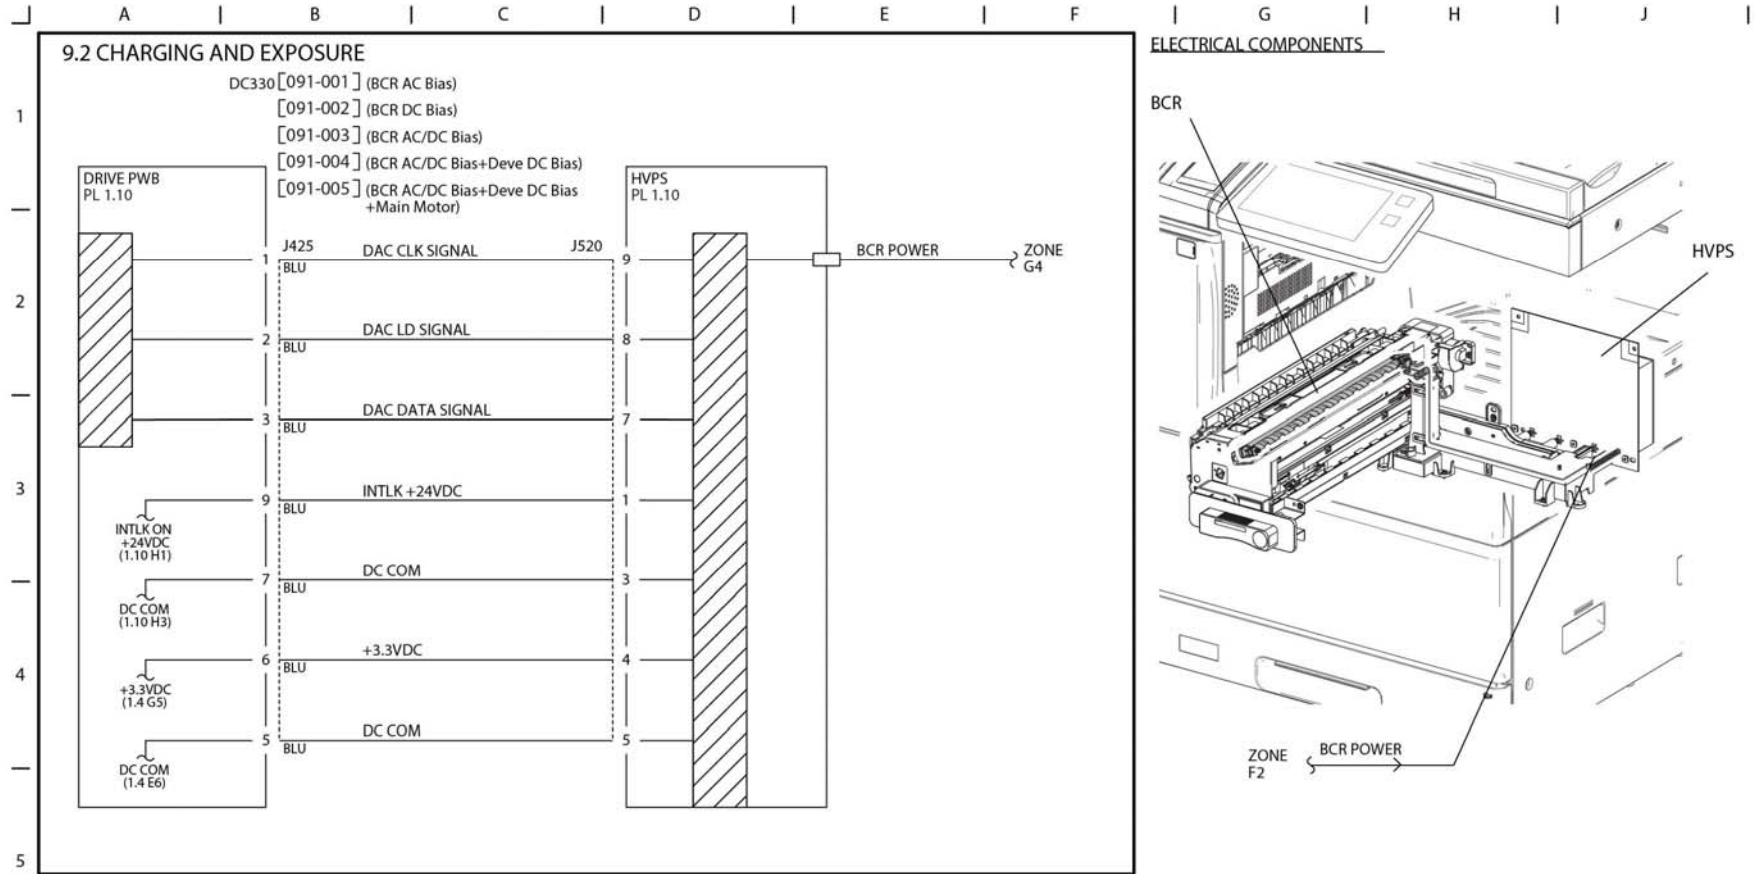
Figure 75 BSD 9.2

BSD 9.2 Charging and Exposure

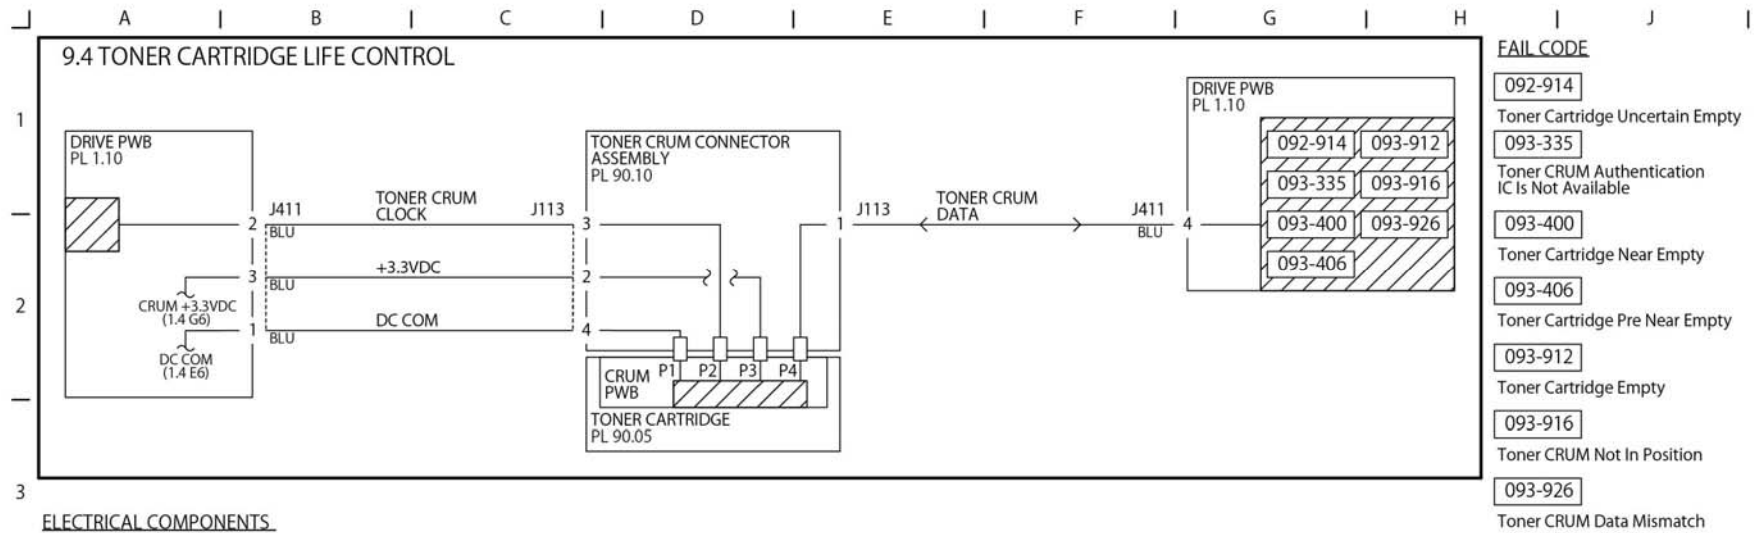
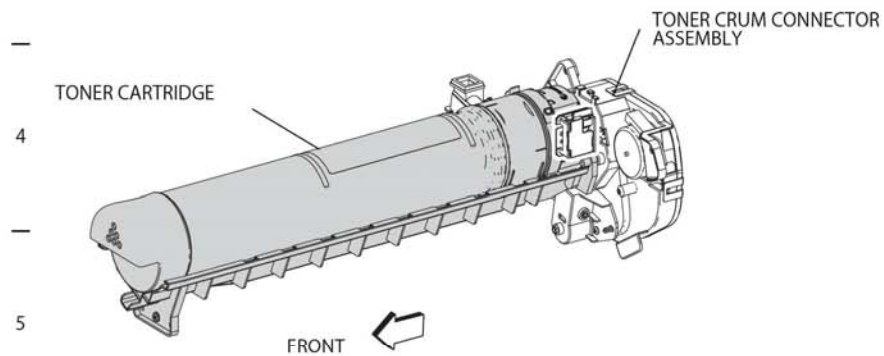
Figure 77 BSD 9.4

BSD 9.4 Toner Cartridge Life Control

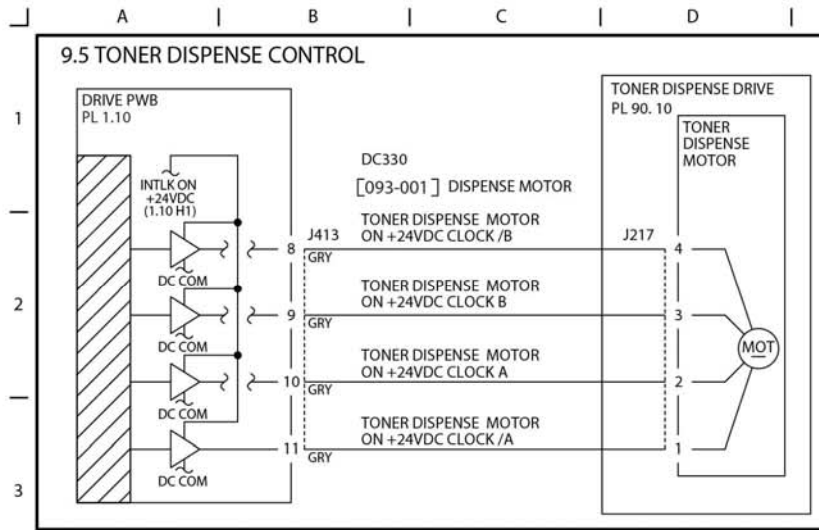
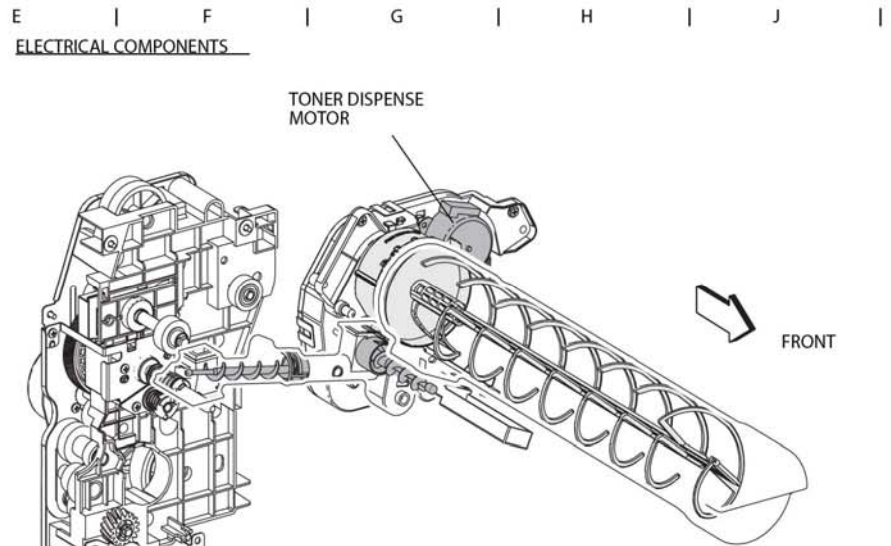
Figure 78 BSD 9.5

BSD 9.5 Toner Dispense Control

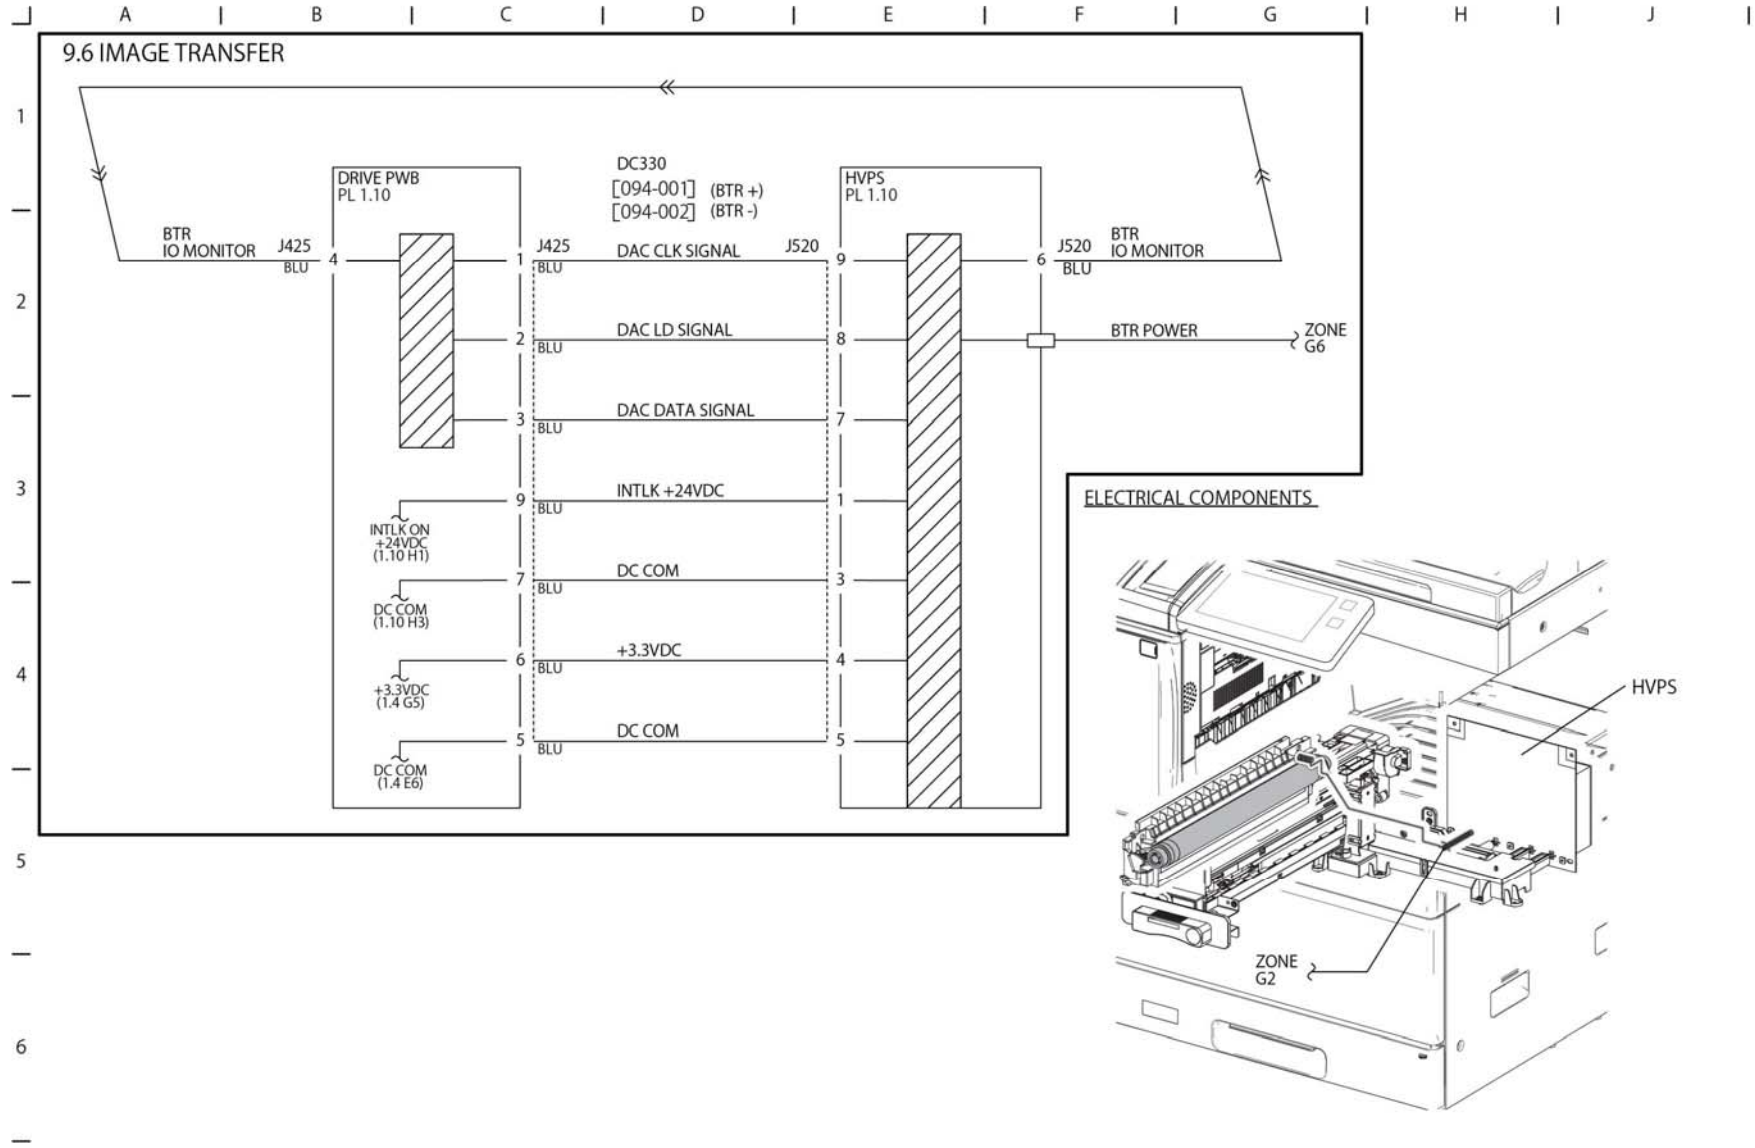
Figure 79 BSD 9.6

BSD 9.6 Image Transfer

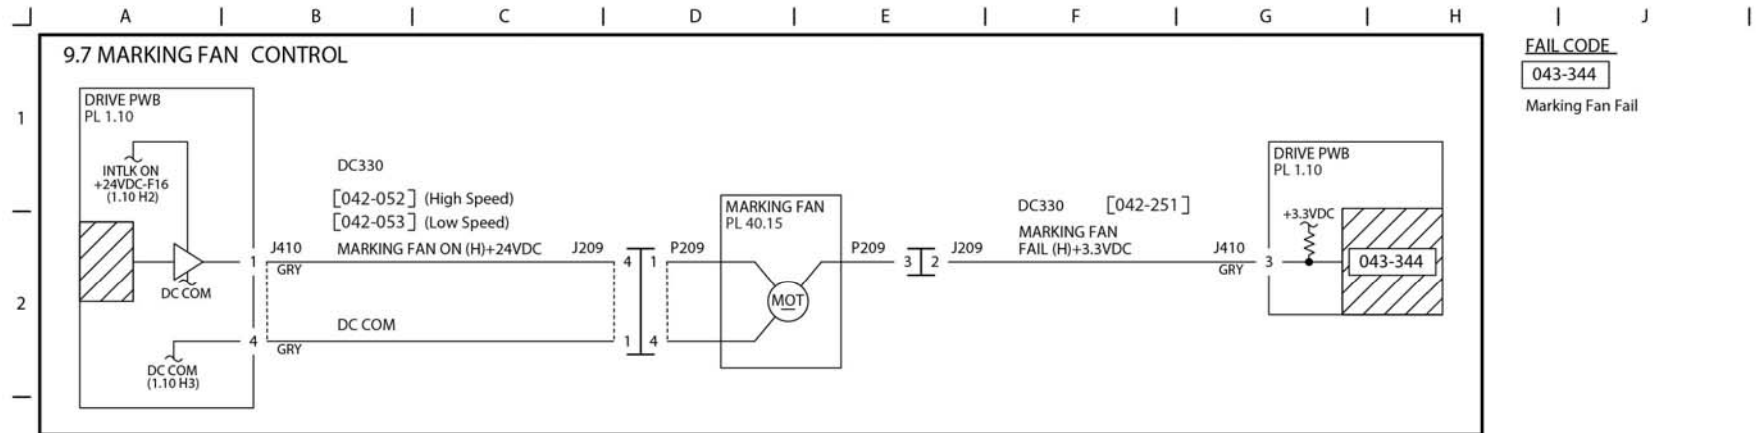
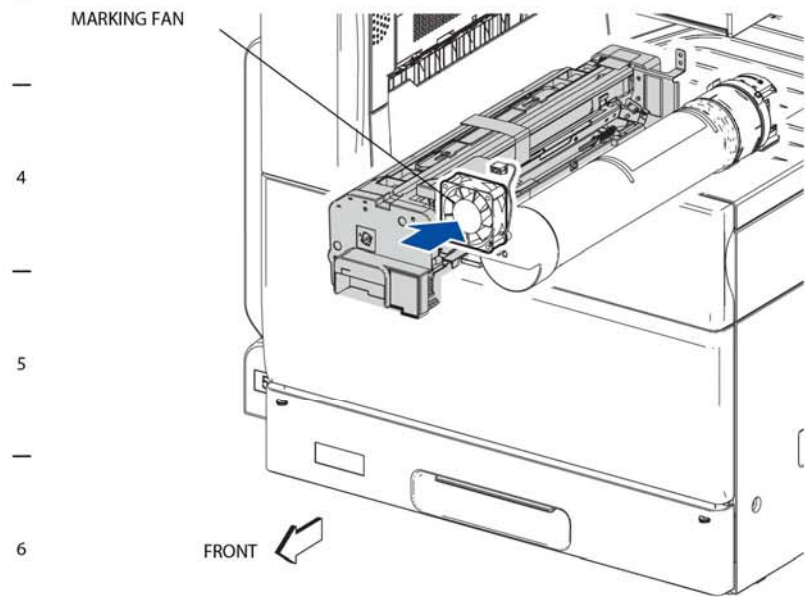
Figure 80 BSD 9.7

BSD 9.7 Marking Fan Control
