708P91370
April 2017

Xerox® VersaLink® B7025/B7030/B7035 Multifunction Printer Service Manual

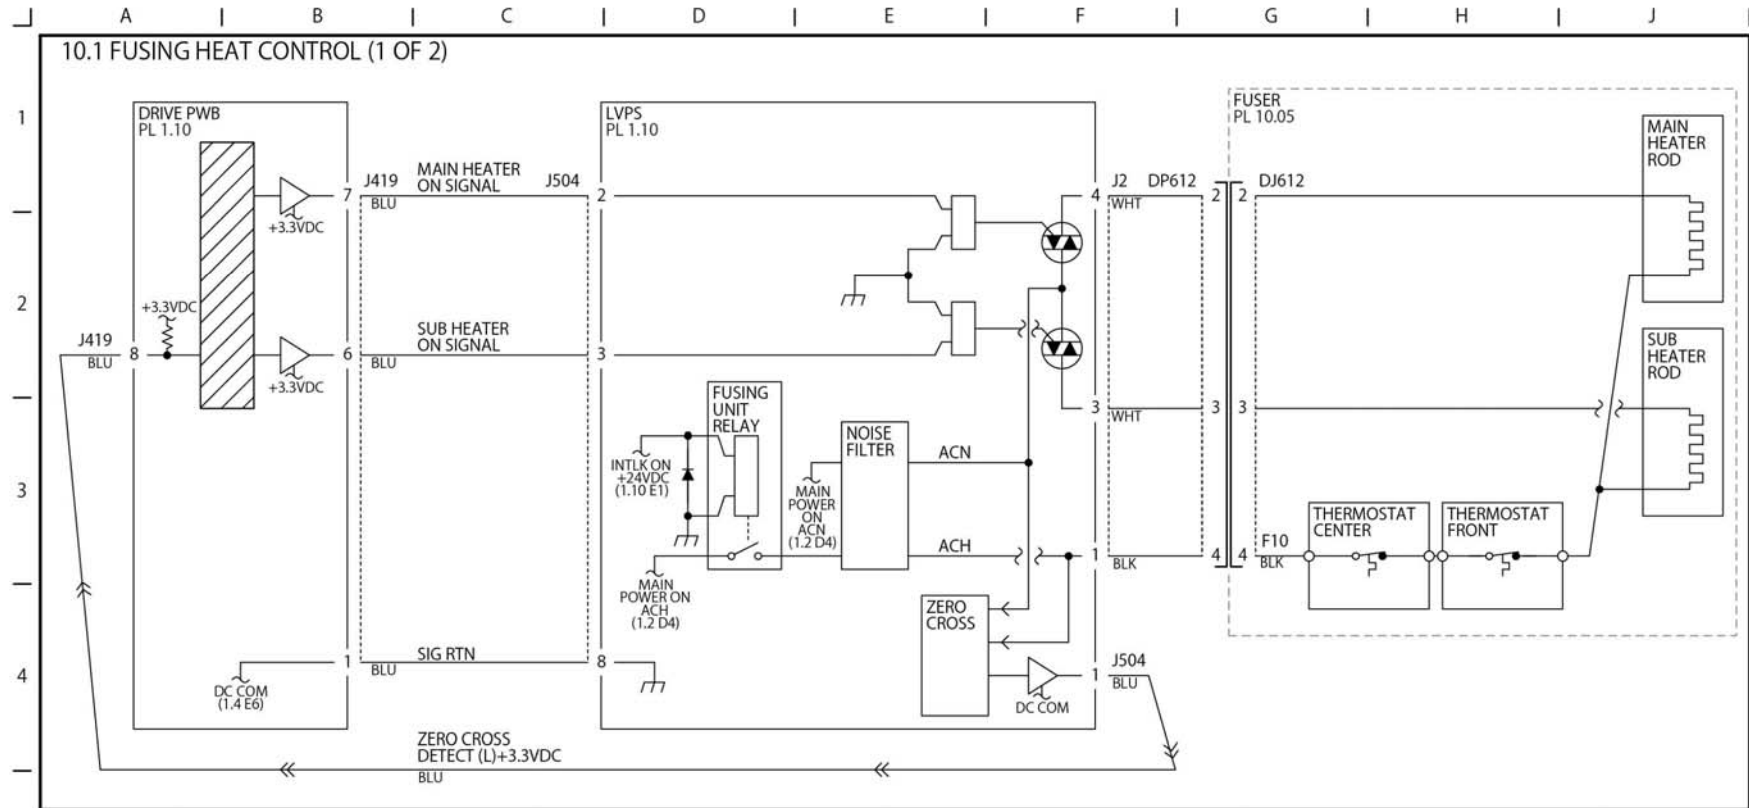
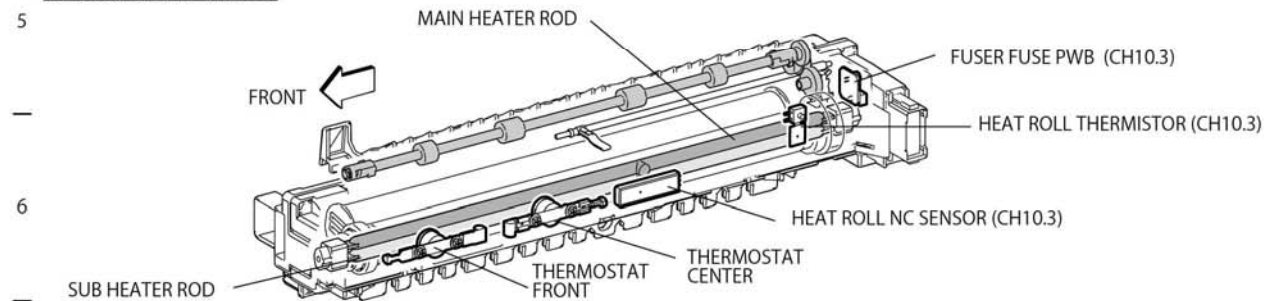
Figure 81 BSD 10.1

BSD 10.1 Fusing Heat Control (1 of 2)

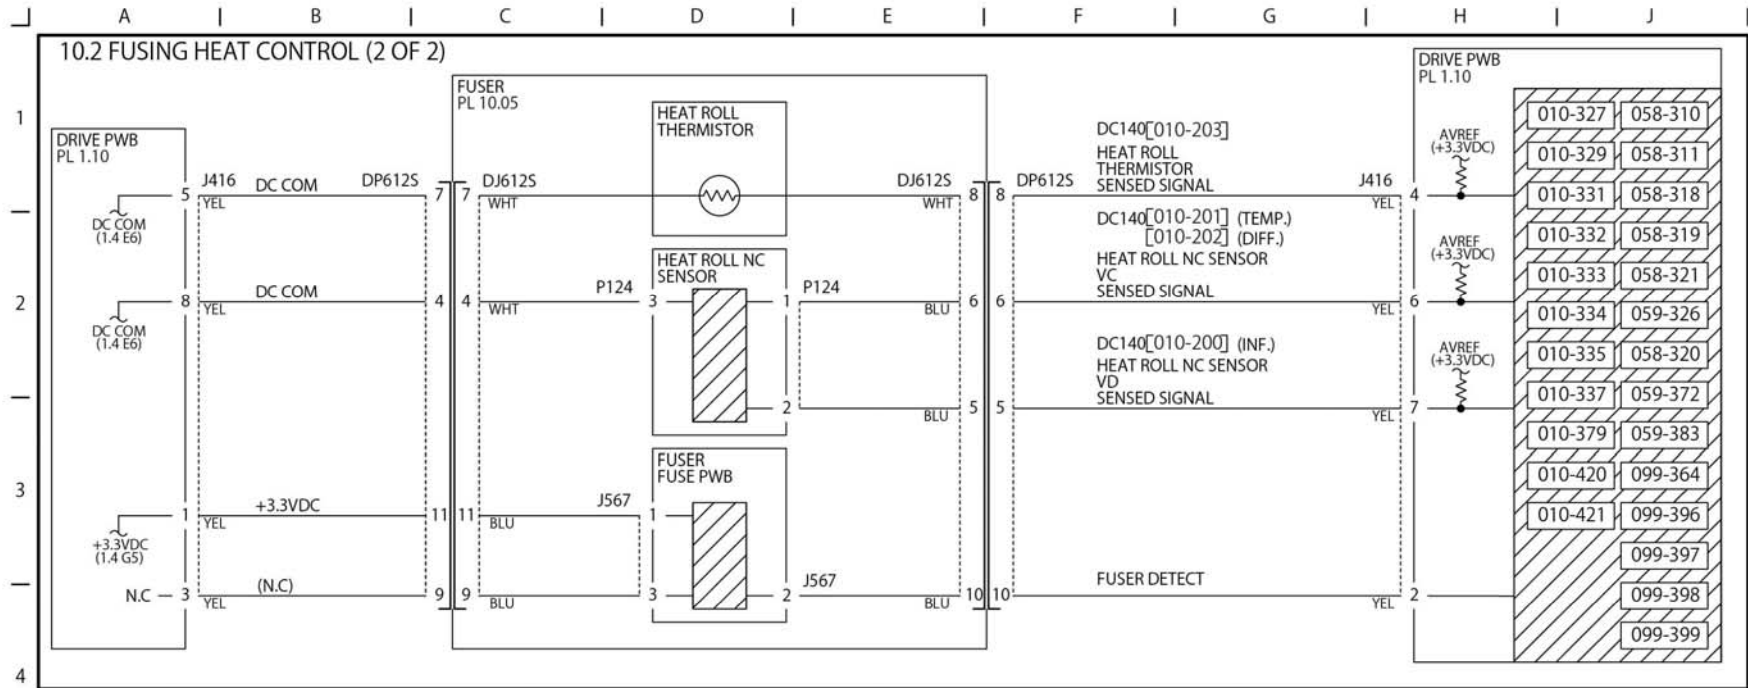
Figure 82 BSD 10.2

BSD 10.2 Fusing Heat Control (2 of 2)

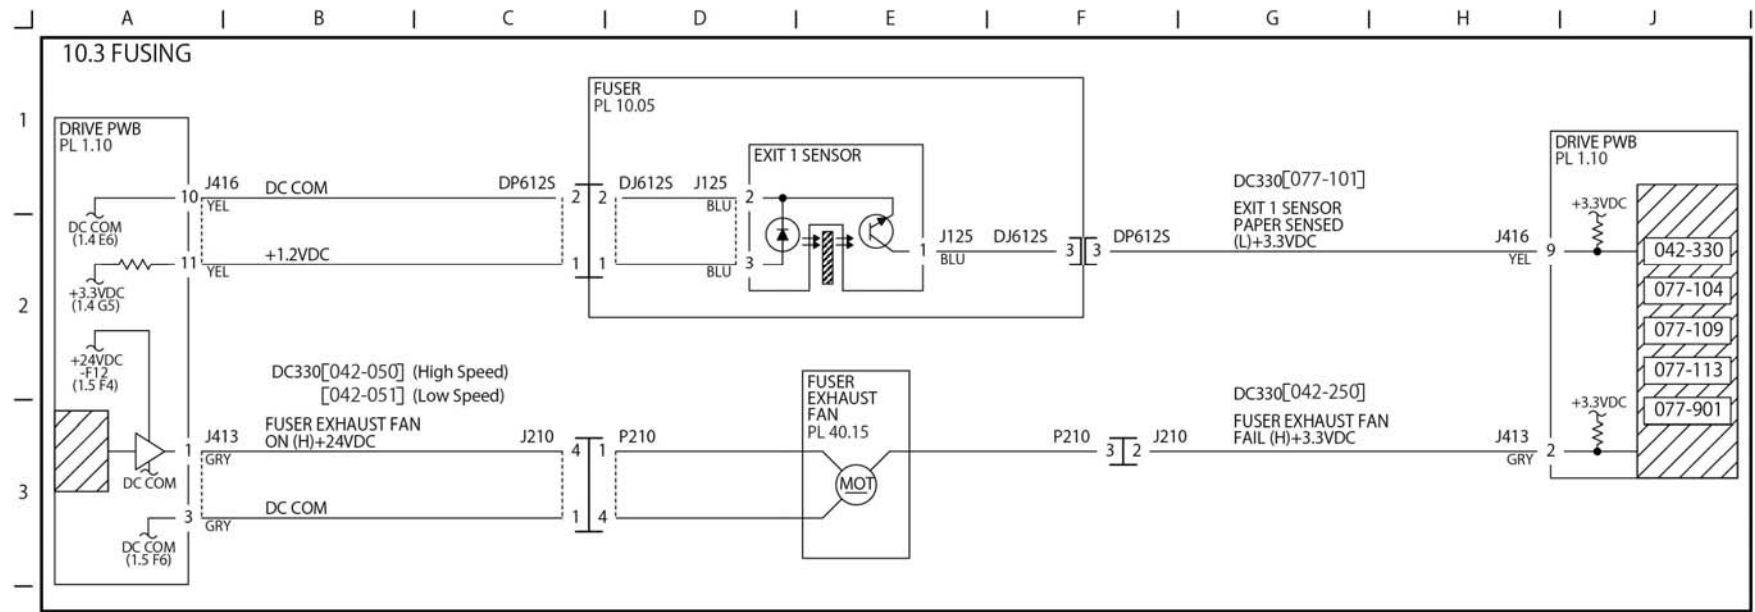
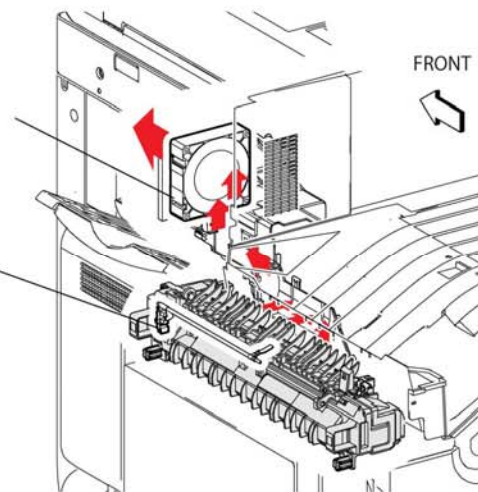
Figure 83 BSD 10.3

BSD 10.3 Fusing

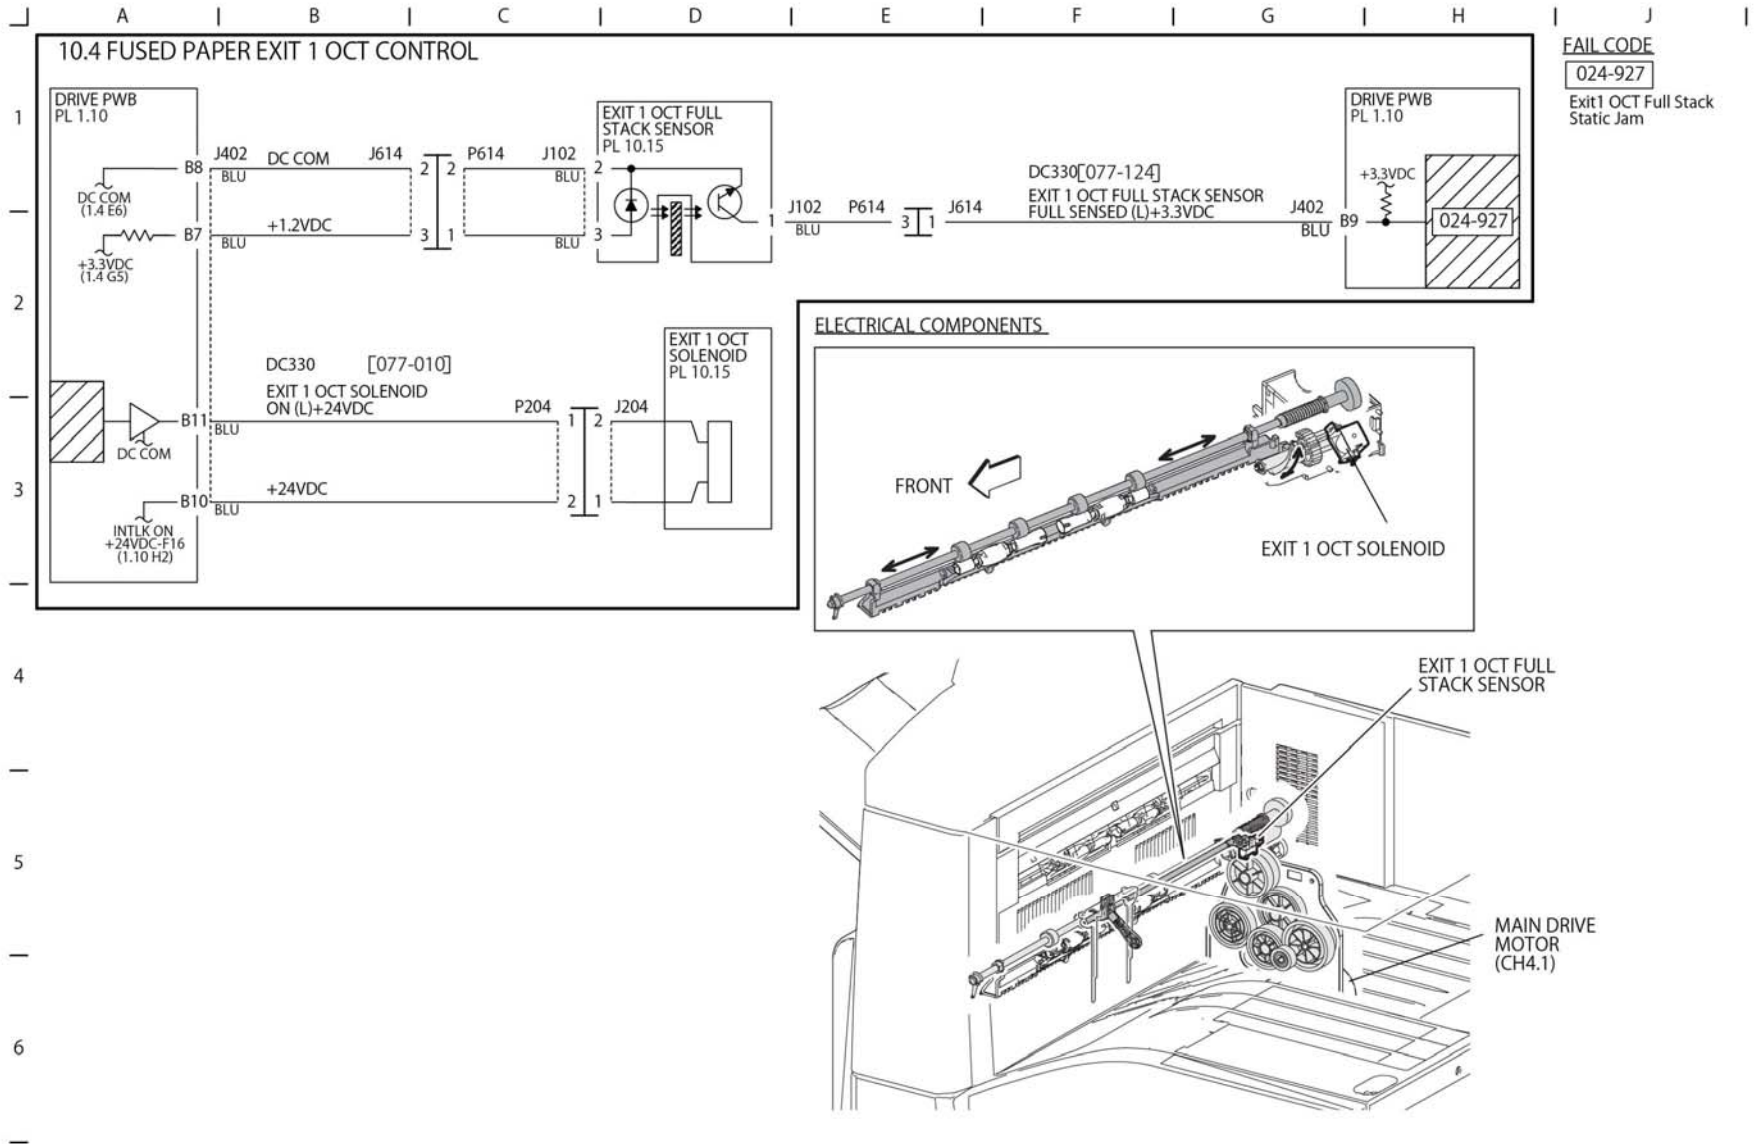
Figure 84 BSD 10.4

BSD 10.4 Fused Paper Exit 1 OCT Control

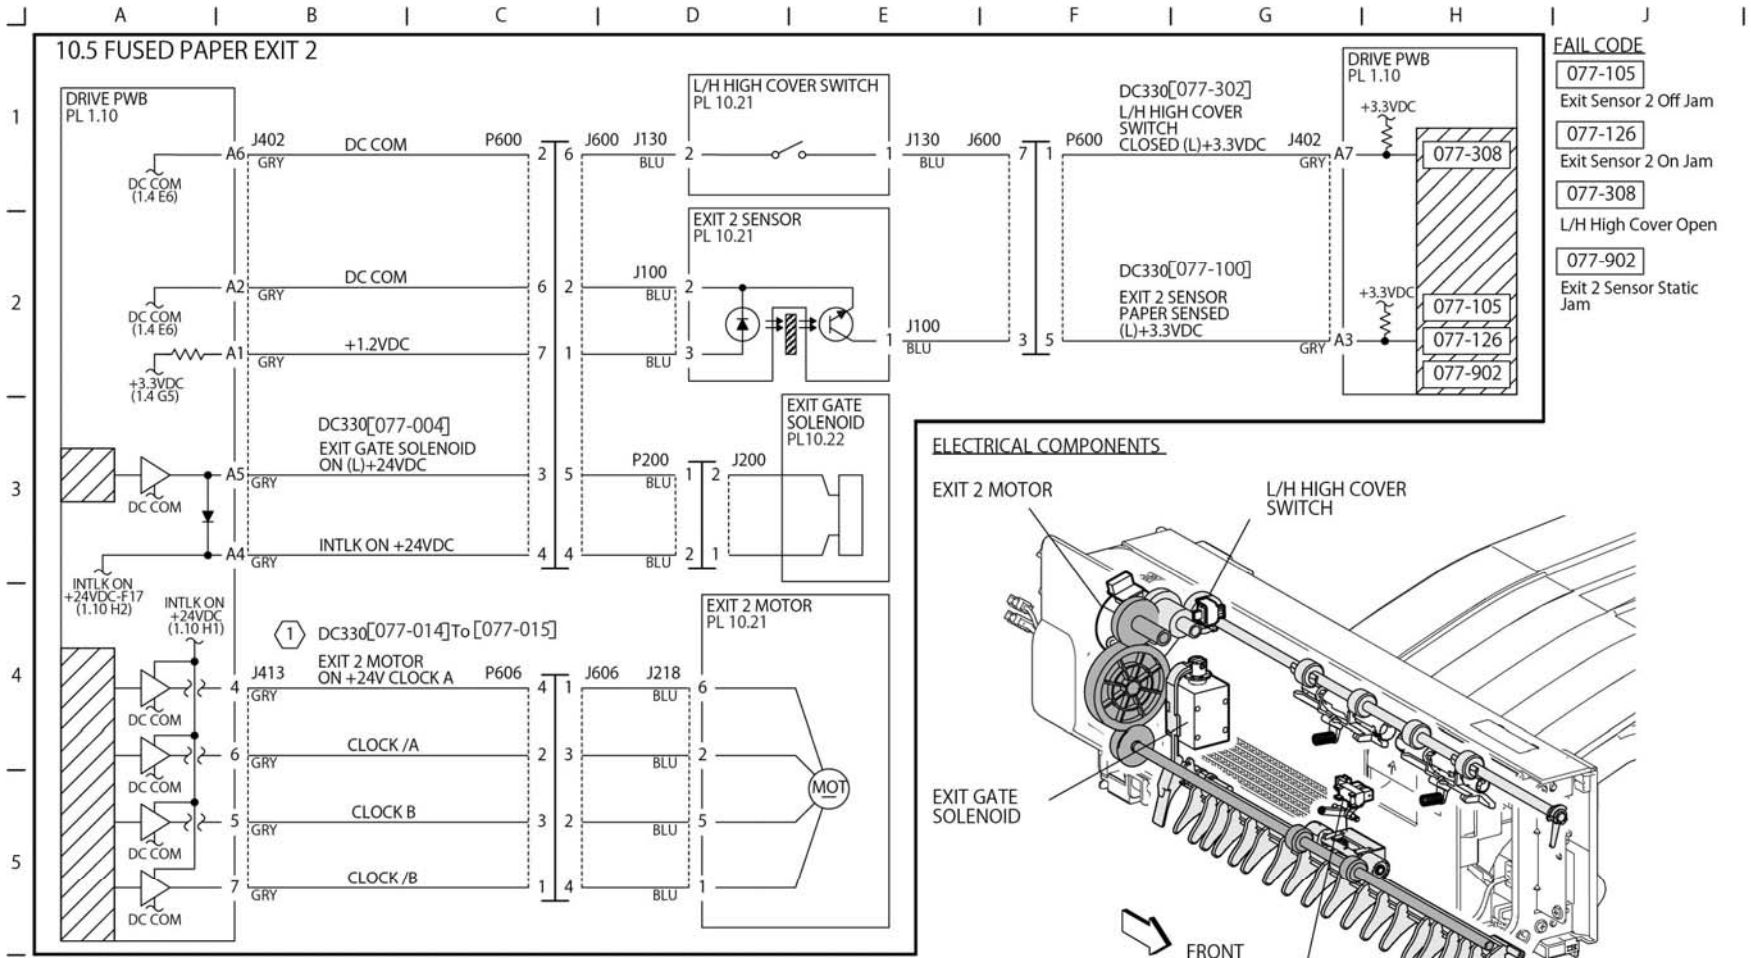
BSD 10.5 Fused Paper Exit 2

NOTE: ① The operation varies depending on the diag code.

EXIT 2 DRIVE MOTOR	Operation
DC330 [077-014]	Rotates the Motor forward. (in exit direction)
DC330 [077-015]	Rotates the Motor reverse. (in Pull-in direction)

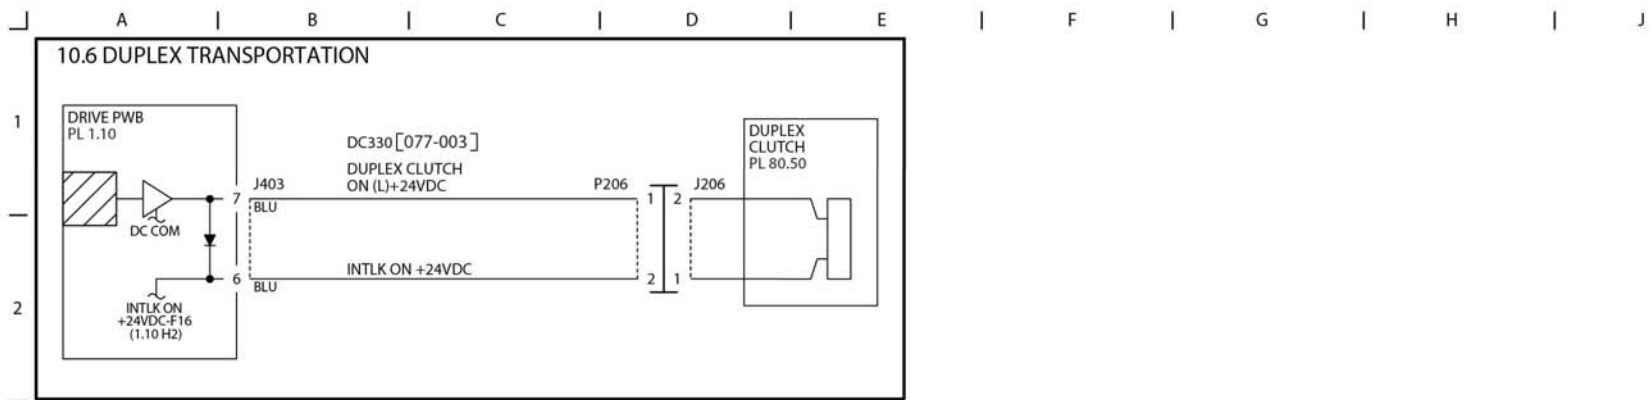
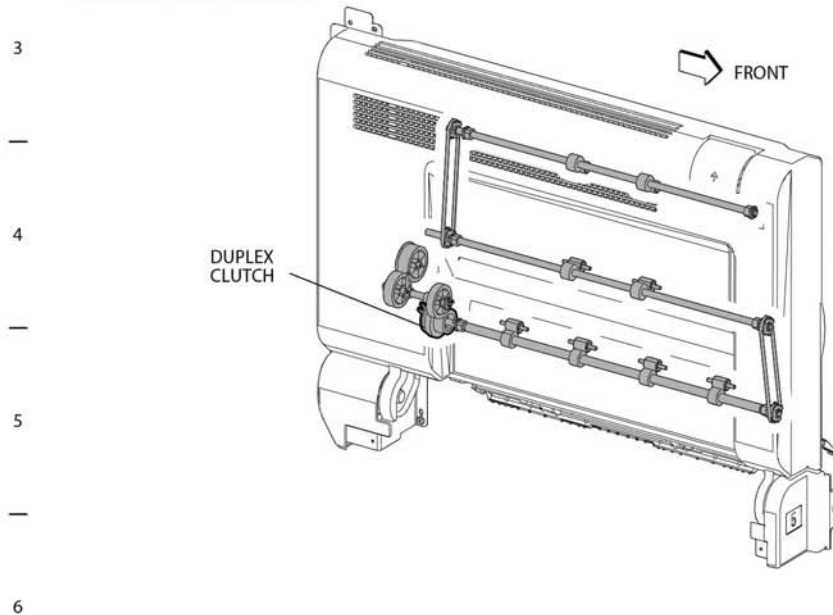
Figure 86 BSD 10.6

BSD 10.6 Duplex Transport

- Duplex sensor - The duplex sensor monitors the duplex path. A duplex path sensor on jam occurs when the sensor fails to turn on a specified time after the exit 2 motor reverses rotation to feed the sheet into the duplex area. A jam in the duplex area may be indicated by the sensor remaining on.

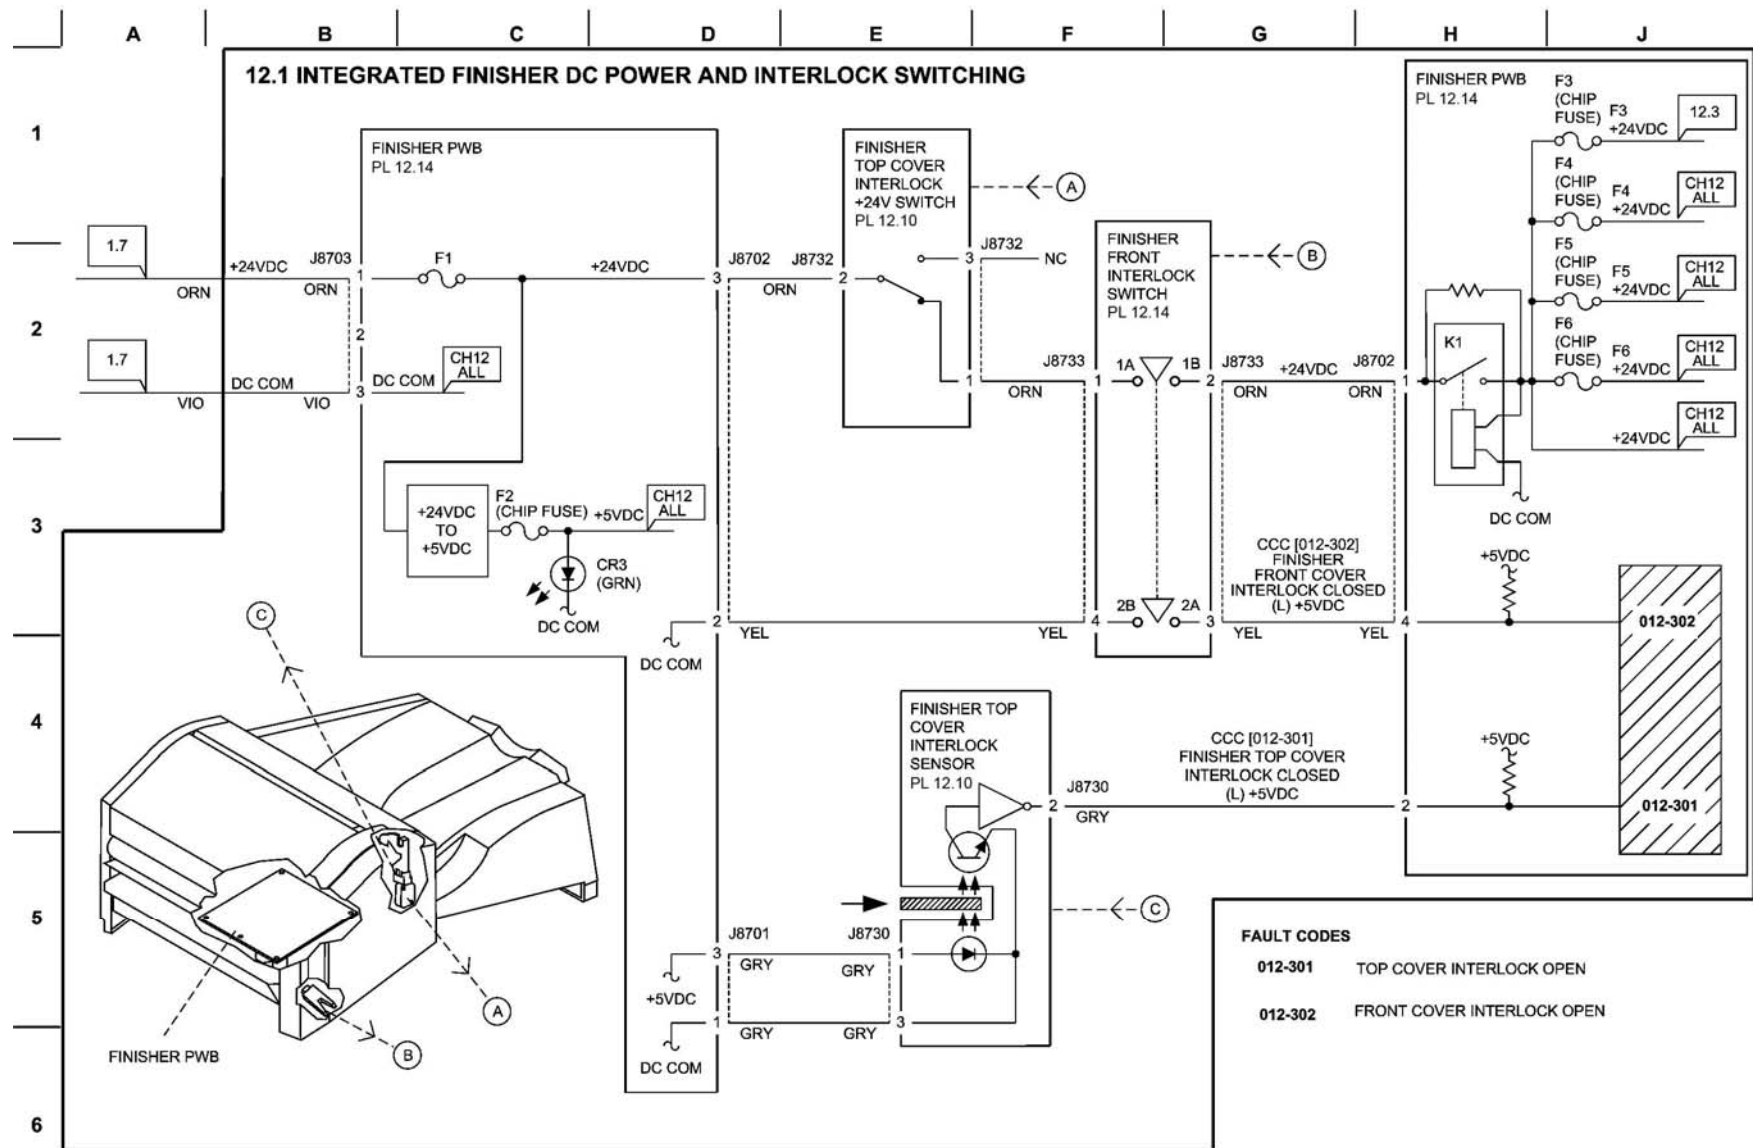
Figure 87 BSD 12.1

BSD 12.1 Integrated Office Finisher DC Power and Interlock Switching

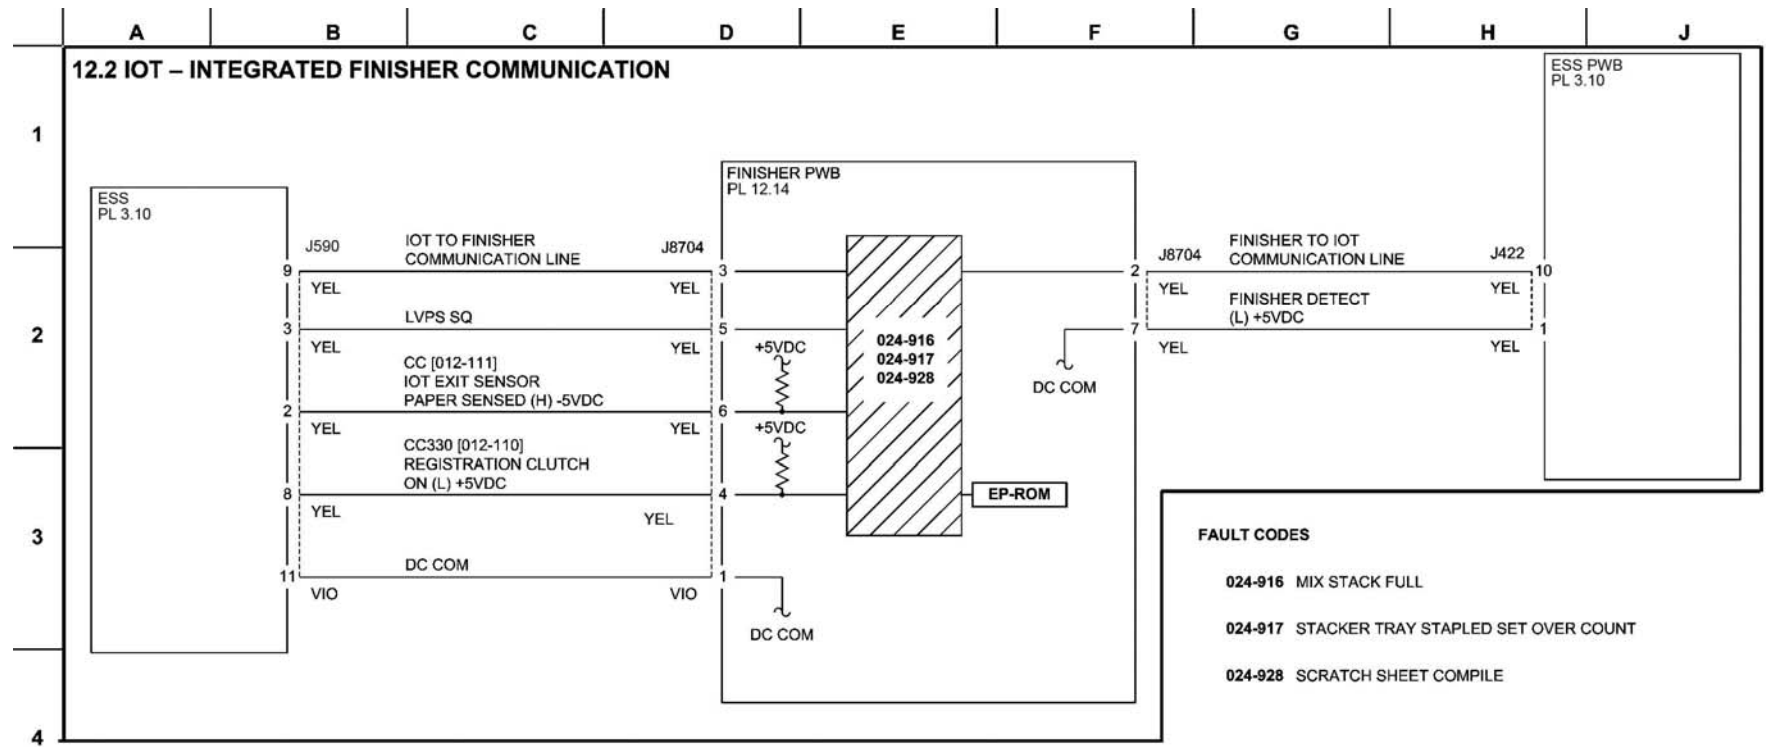
Figure 88 BSD 12.2

BSD 12.2 IOT to Integrated Office Finisher Communication

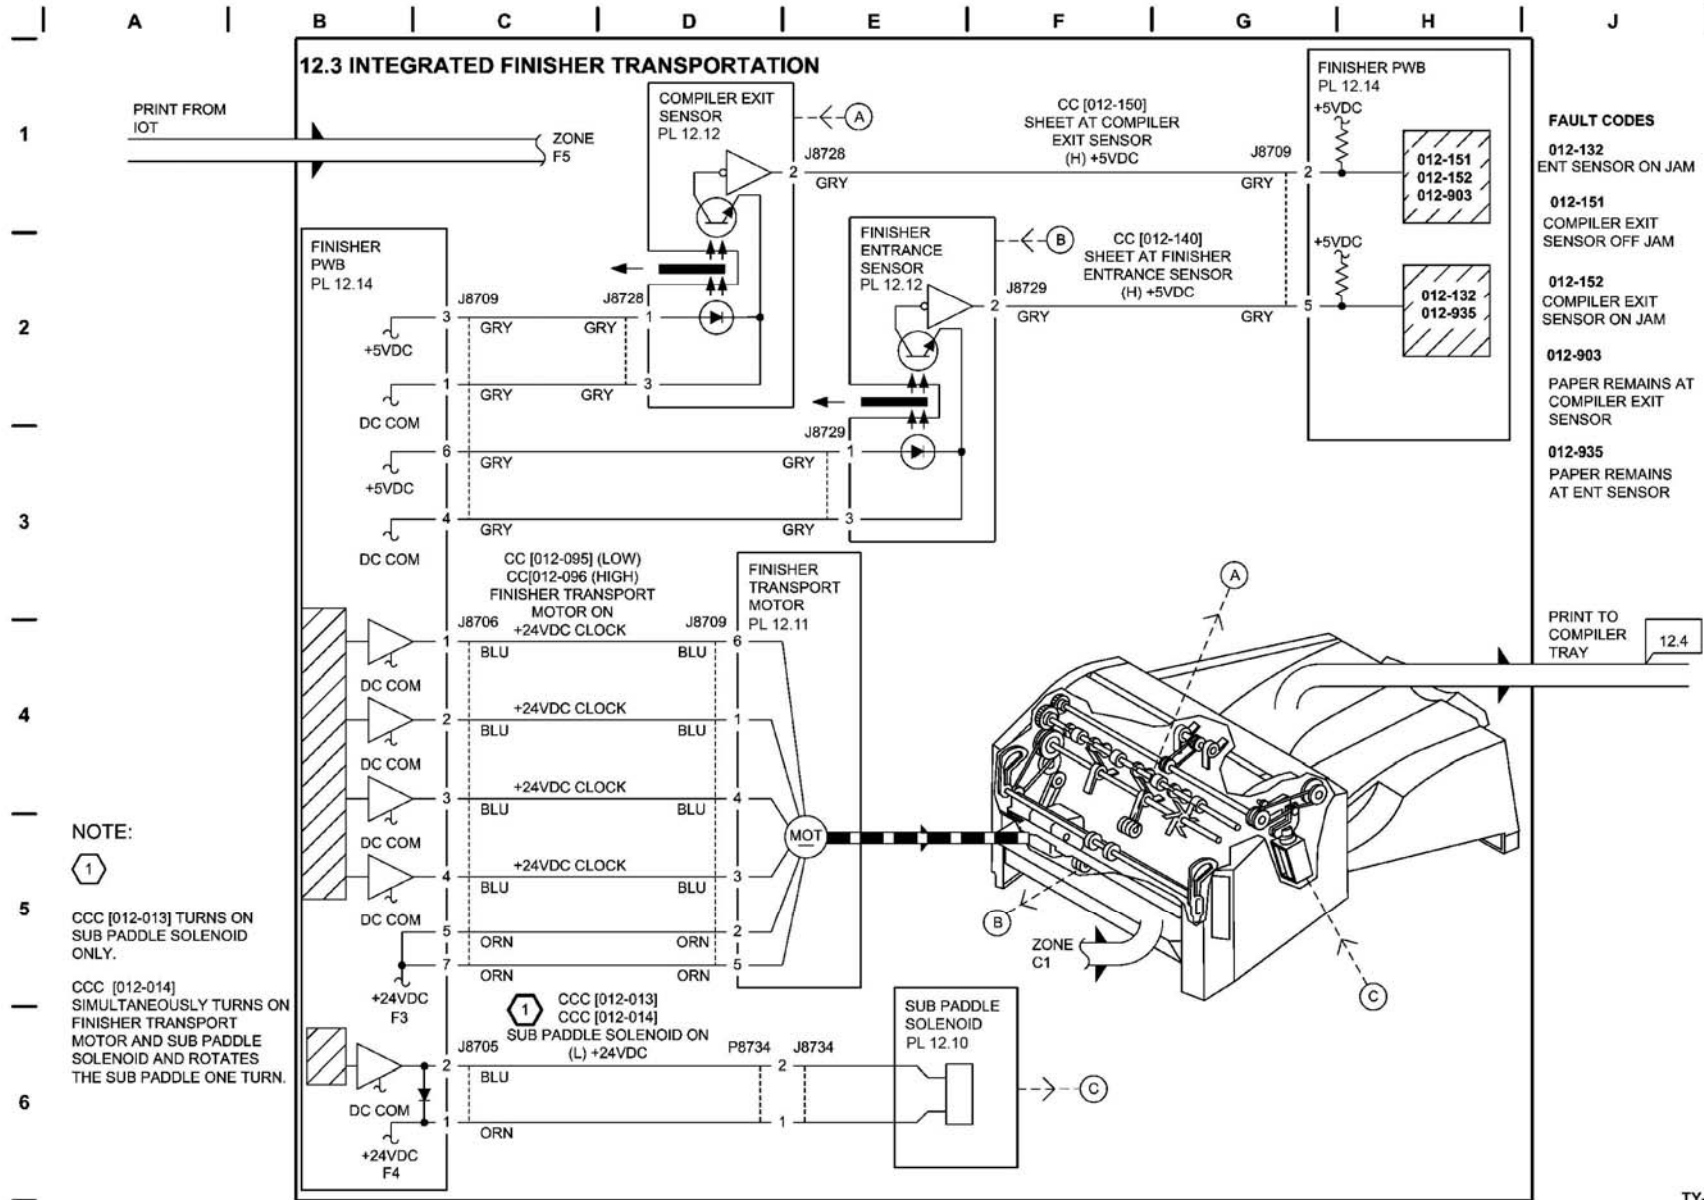
Figure 89 BSD 12.3

BSD 12.3 Integrated Office Finisher Transportation

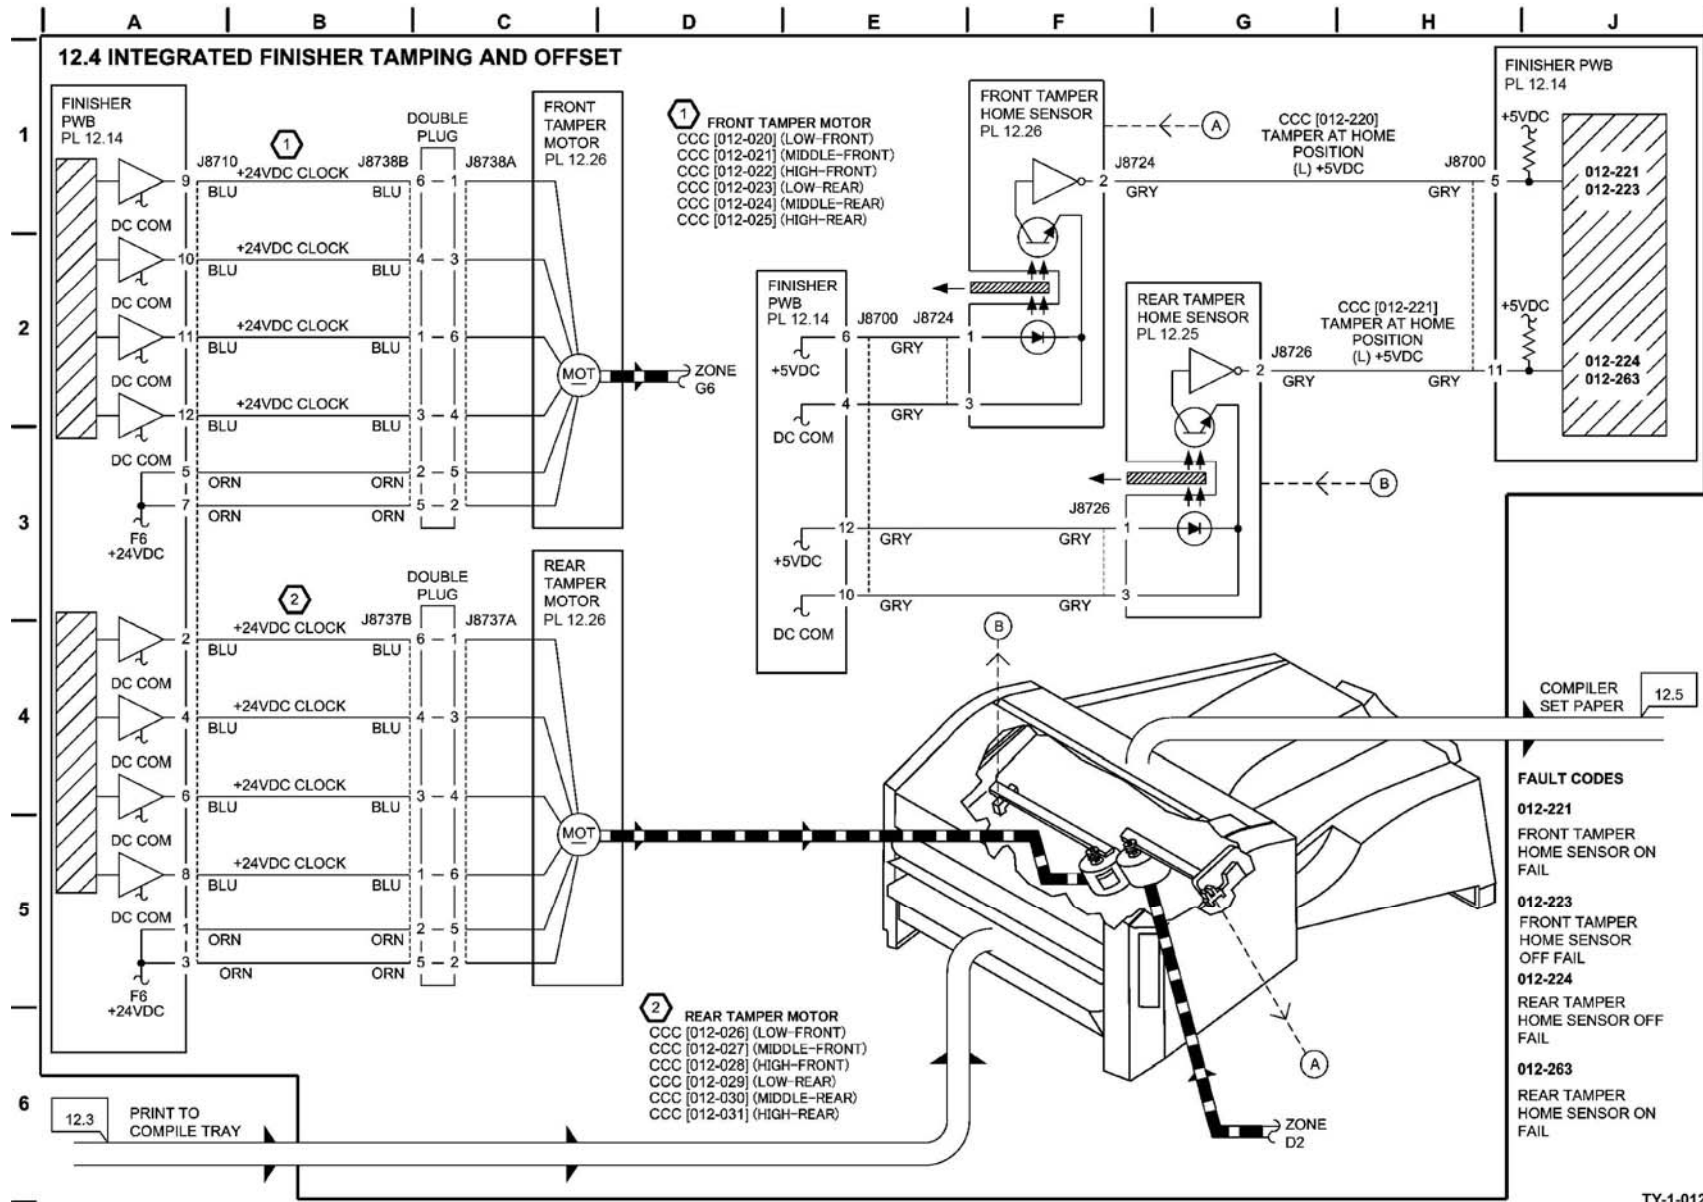
Figure 90 BSD 12.4

BSD 12.4 Integrated Office Finisher Tamping and Offset

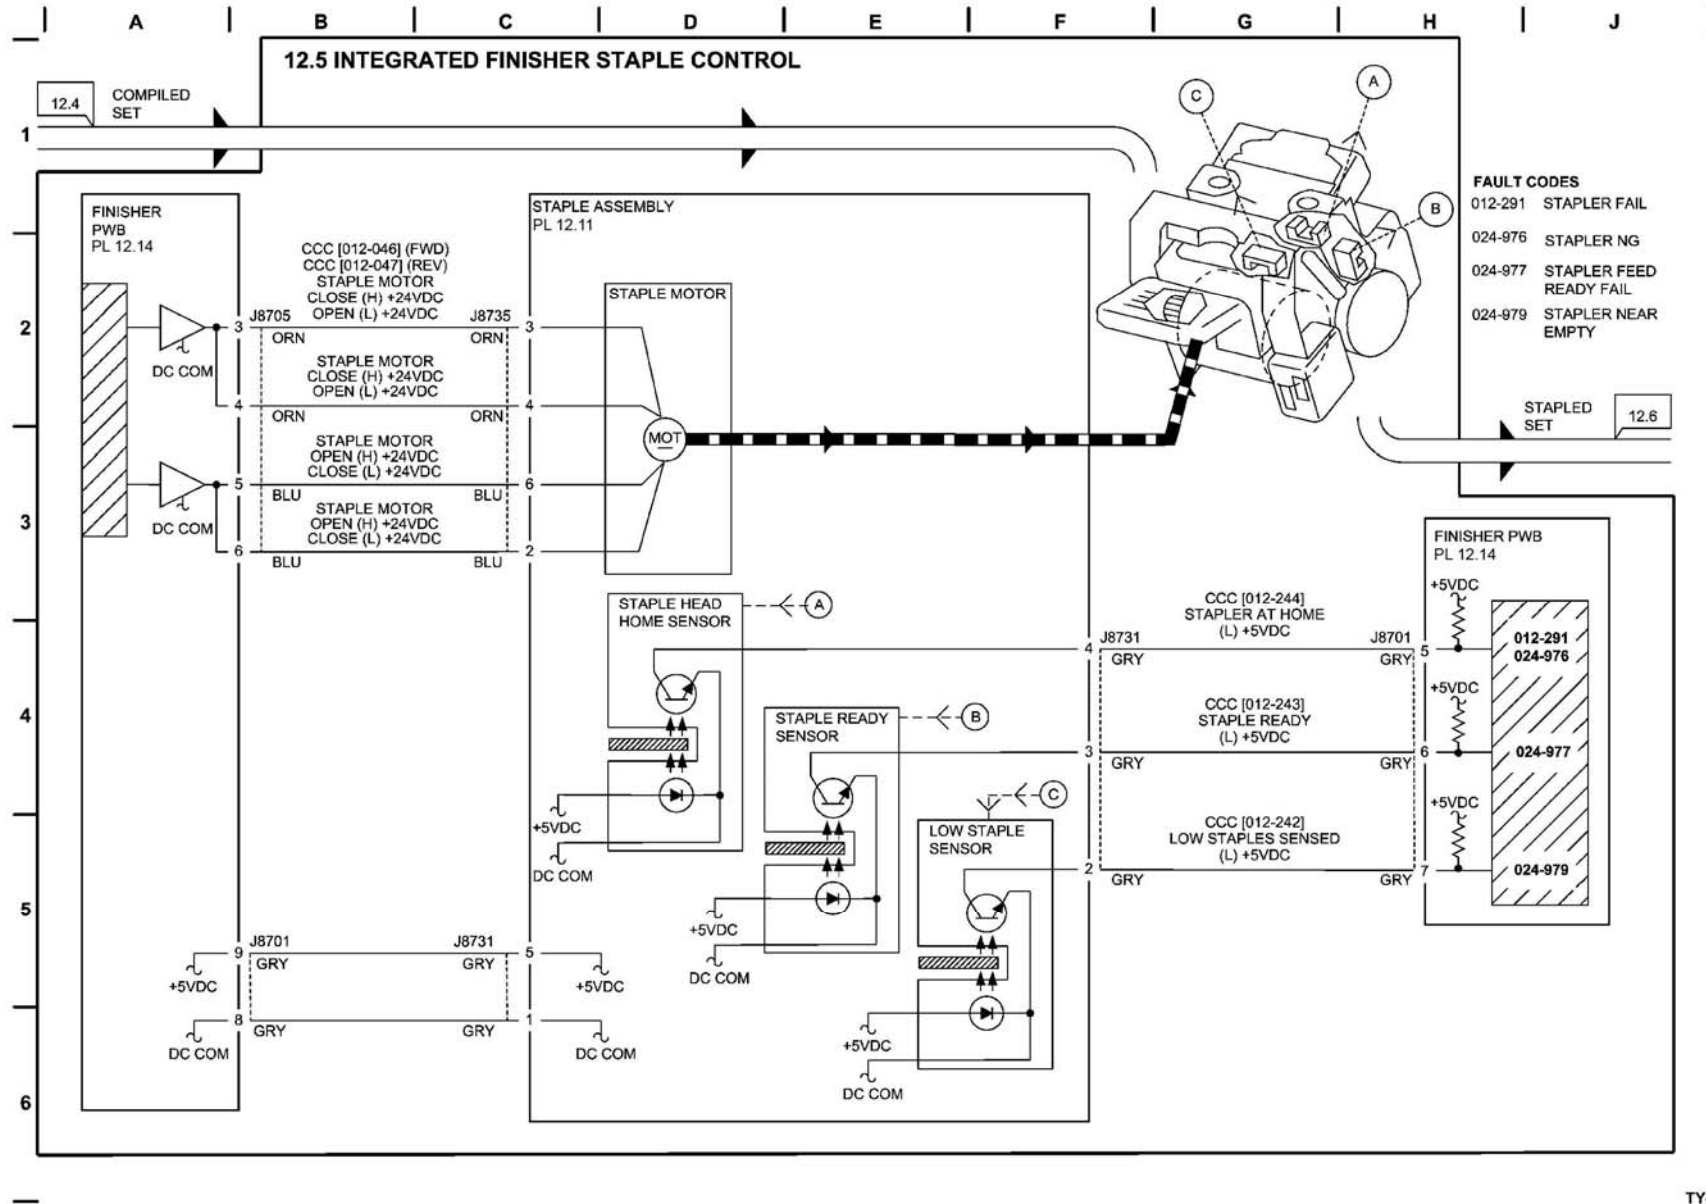
Figure 91 BSD 12.5

BSD 12.5 Integrated Office Finisher Staple Control

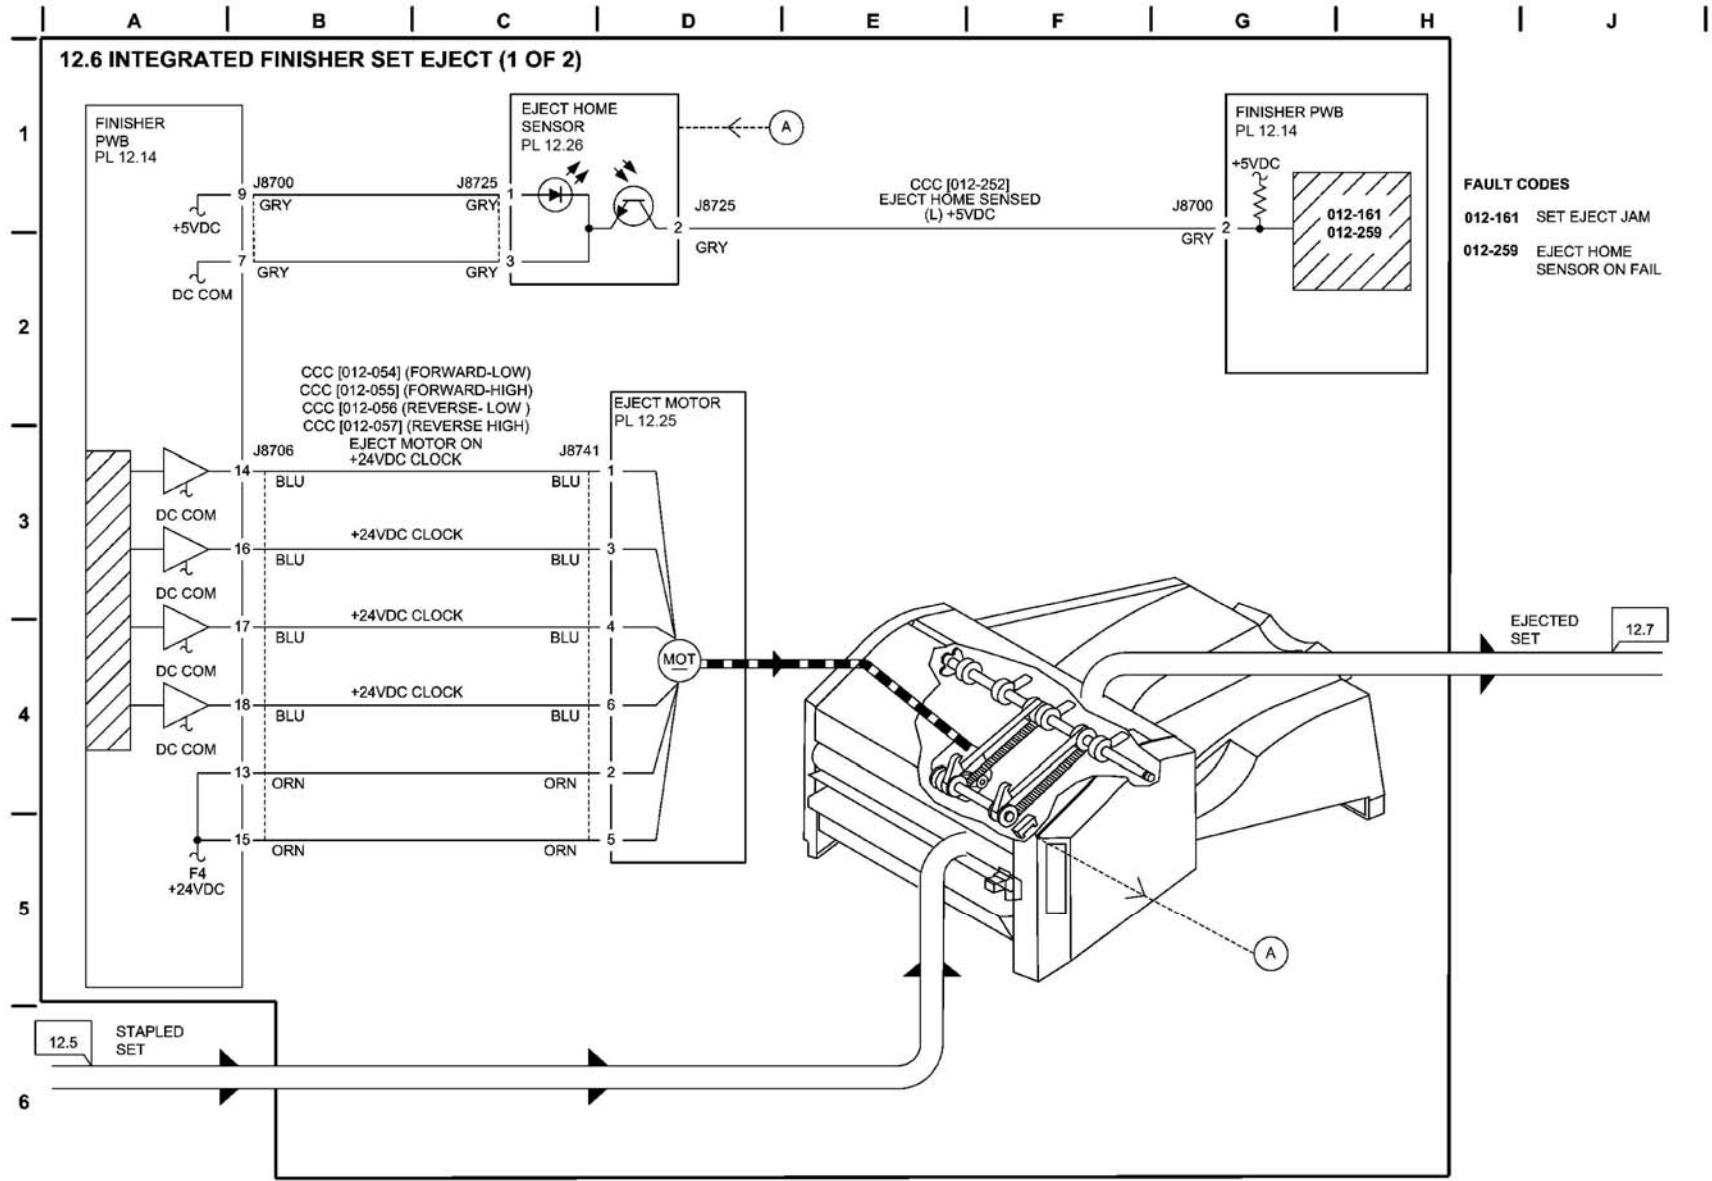
Figure 92 BSD 12.6

BSD 12.6 Integrated Office Finisher Set Eject (1 of 2)

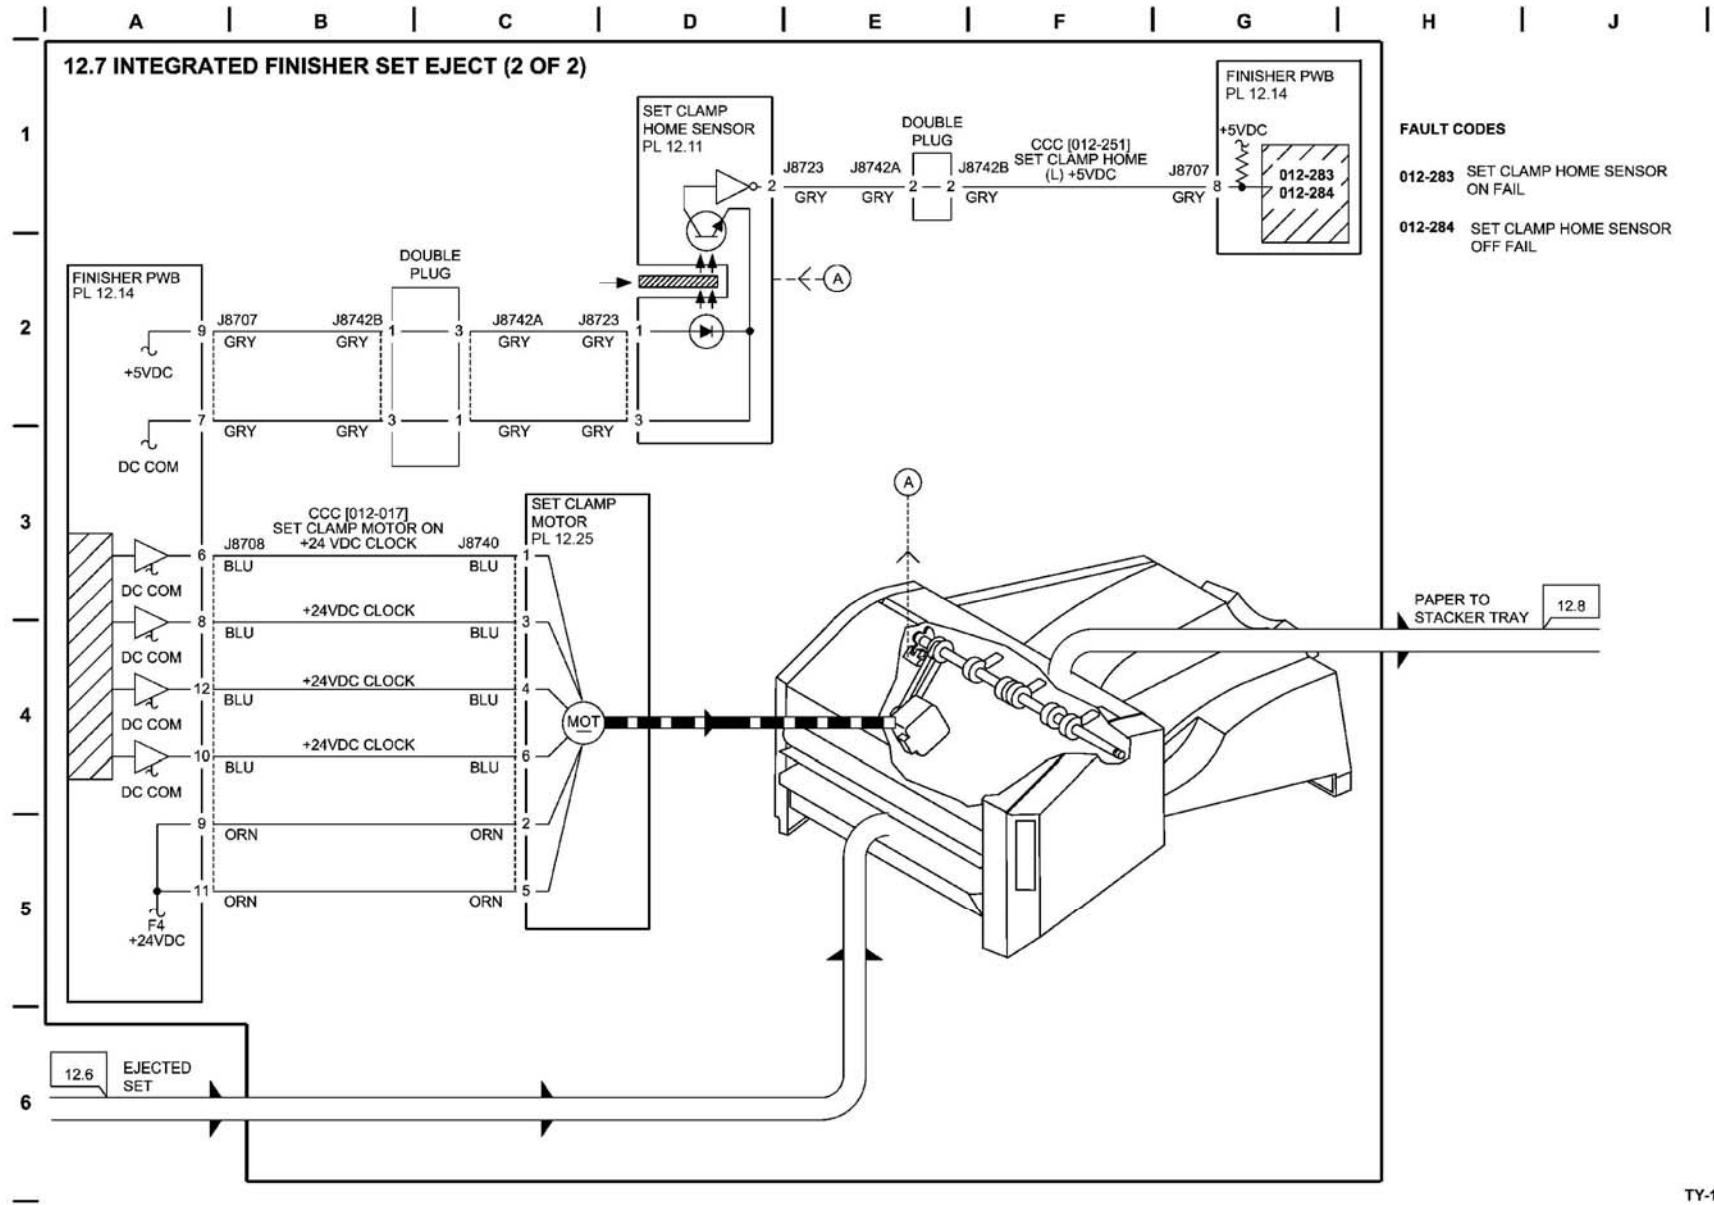
Figure 93 BSD 12.7

BSD 12.7 Integrated Office Finisher Set Eject (2 of 2)
