708P91370
April 2017

Xerox® VersaLink® B7025/B7030/B7035 Multifunction Printer Service Manual

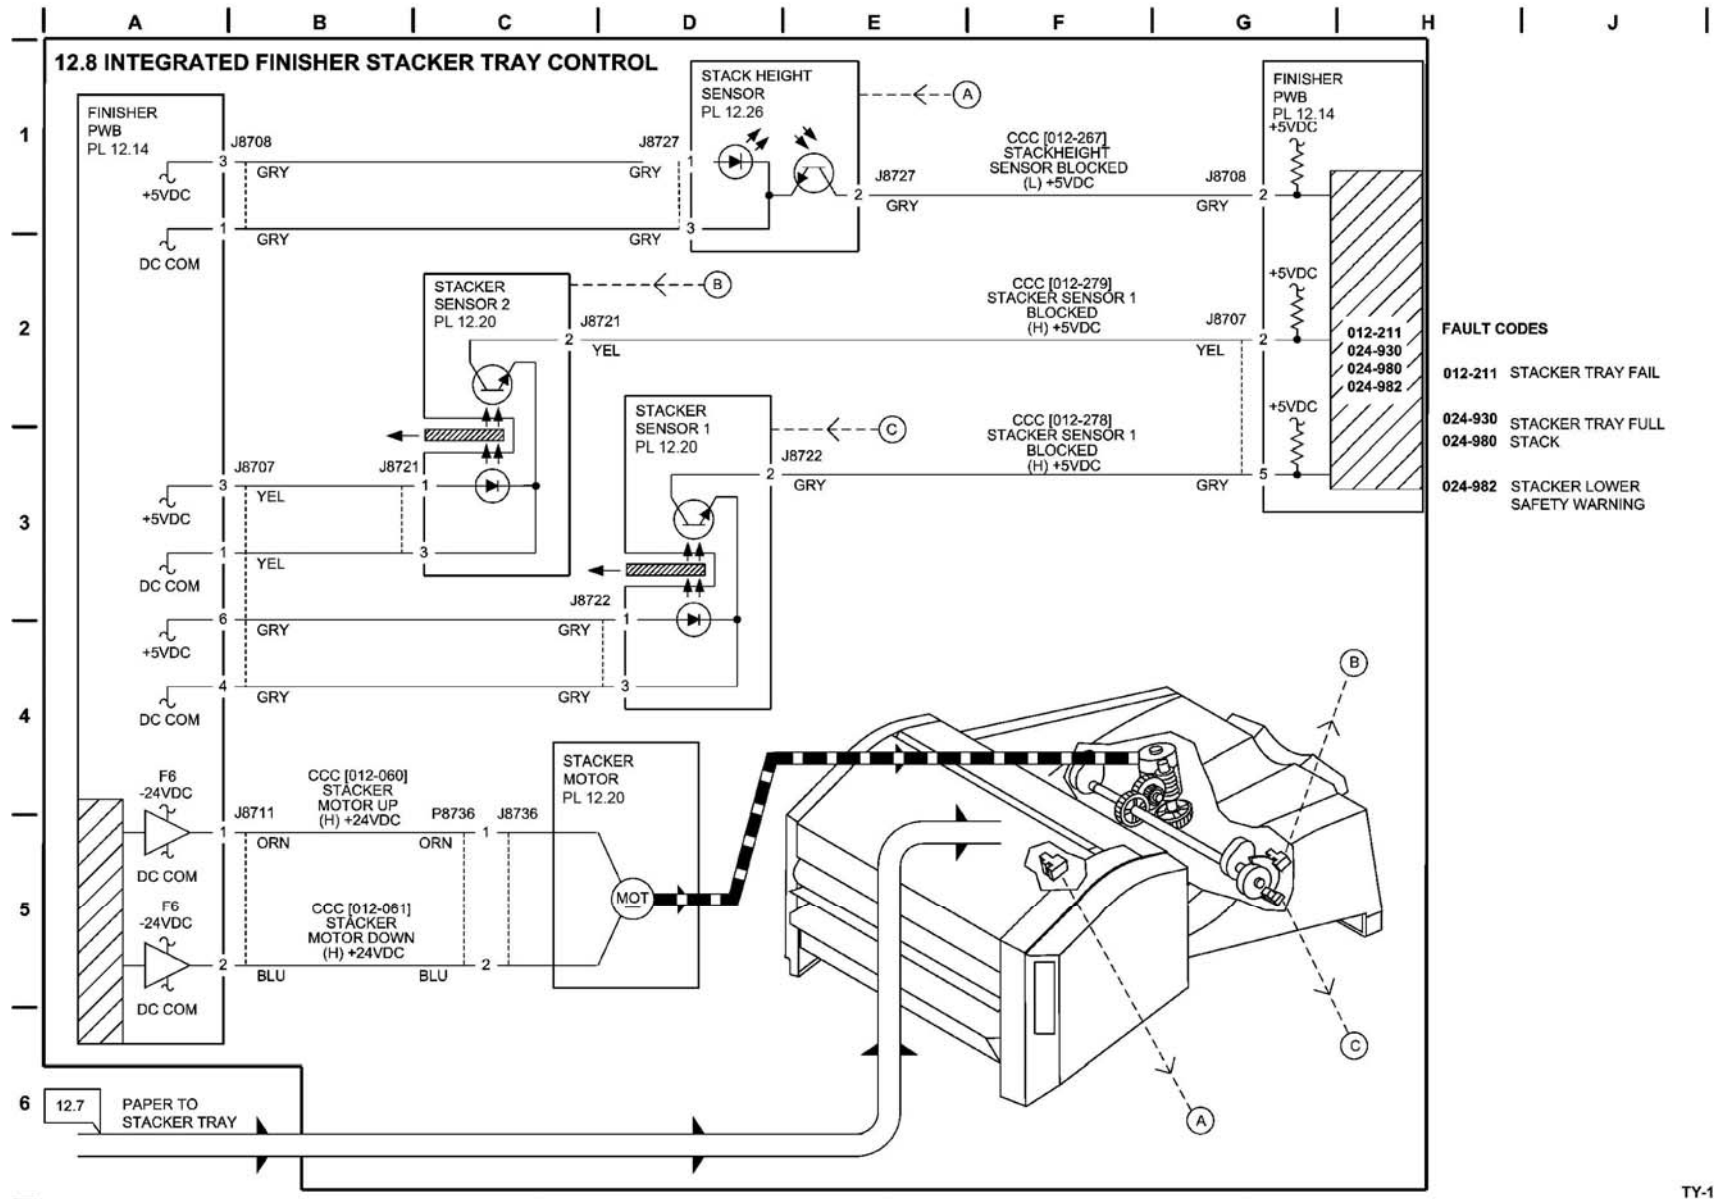
Figure 94 BSD 12.8

BSD 12.8 Integrated Office Finisher Stacker Tray Control

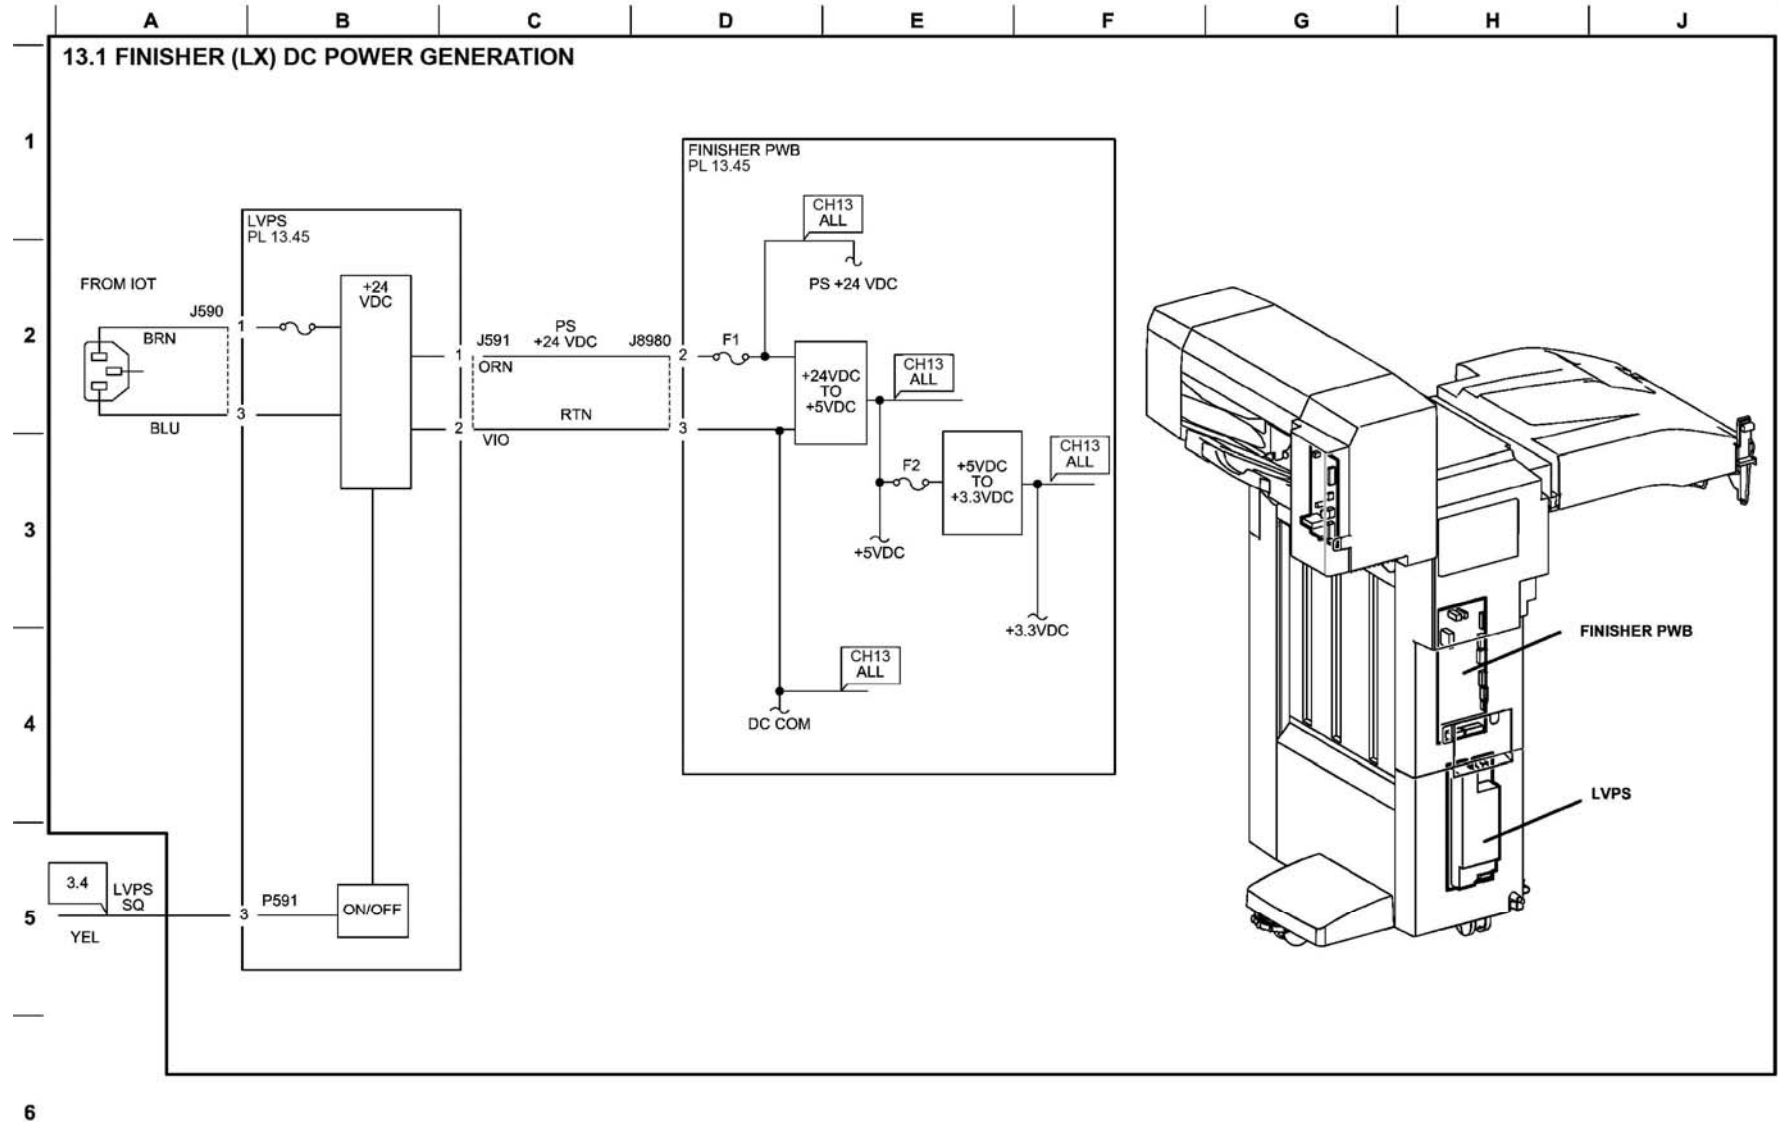
Figure 95 BSD 13.1

BSD 13.1 Office Finisher LX DC Power Generation

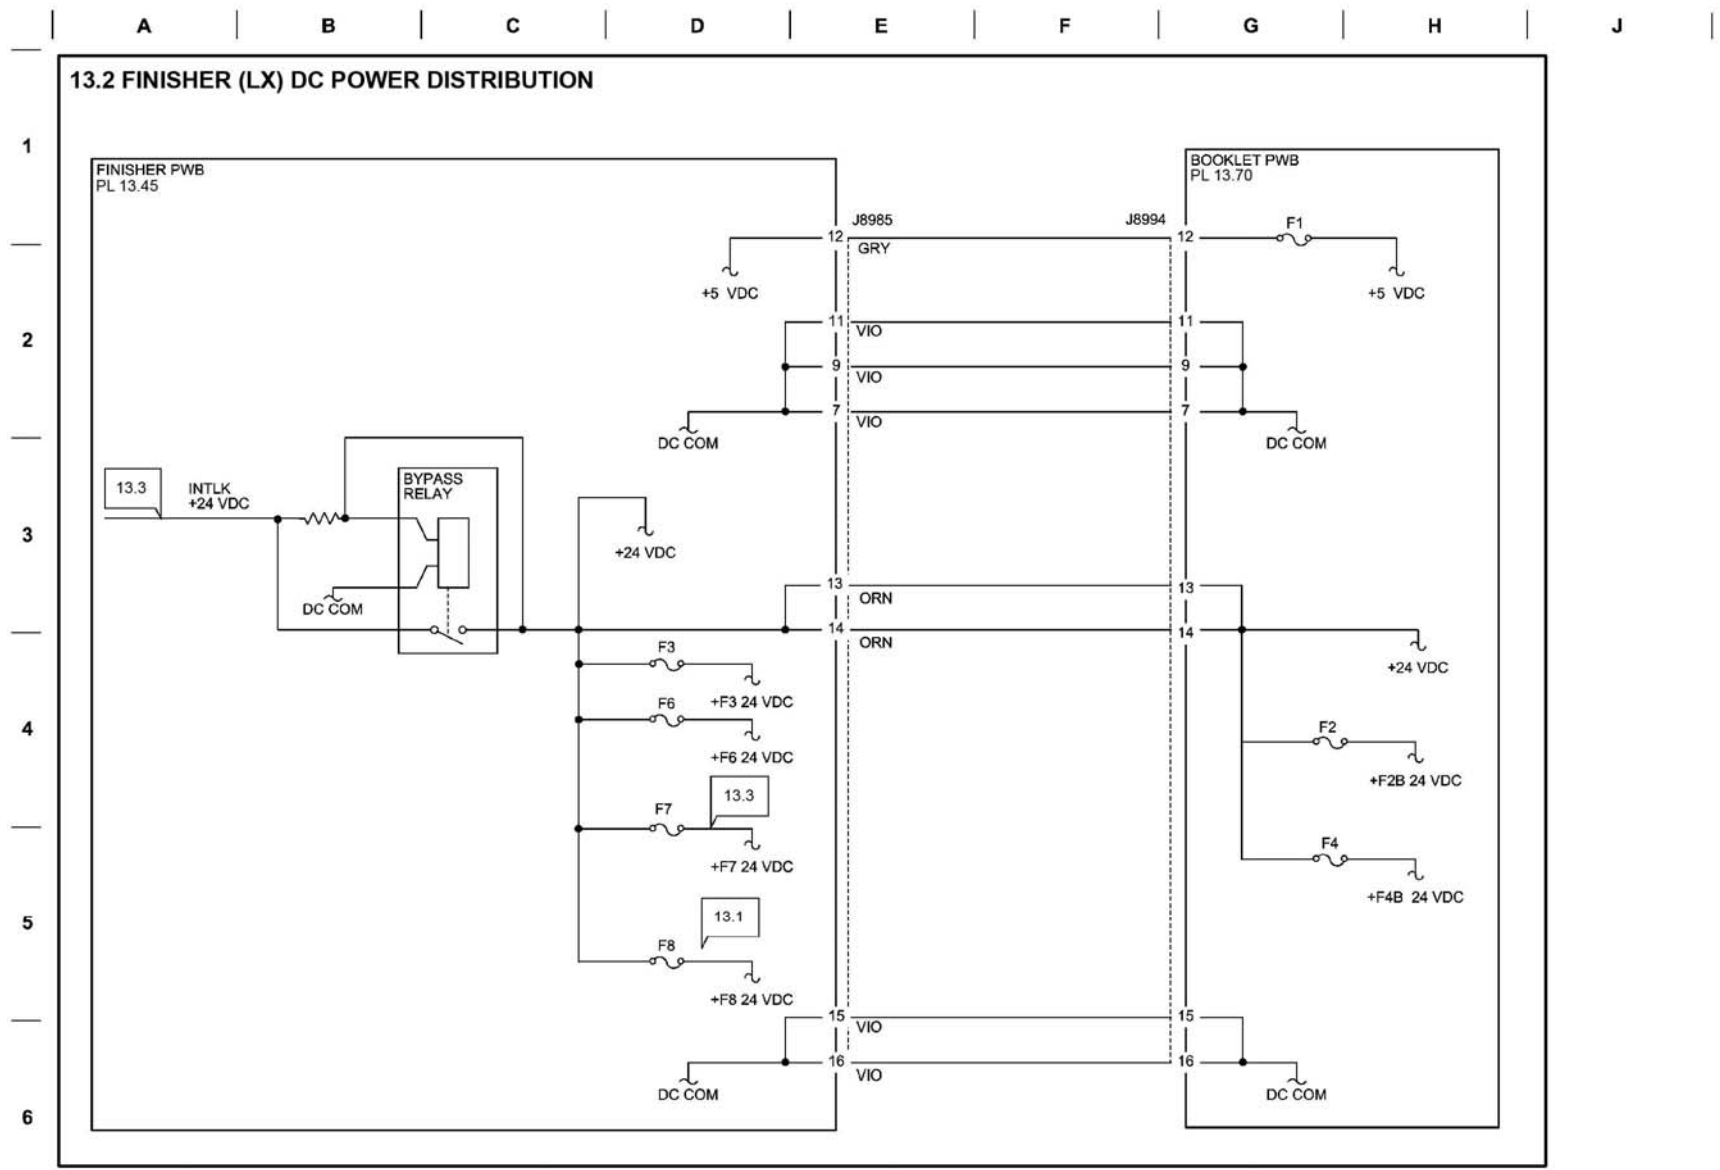
Figure 96 BSD 13.2

BSD 13.2 Office Finisher LX DC Power Distribution

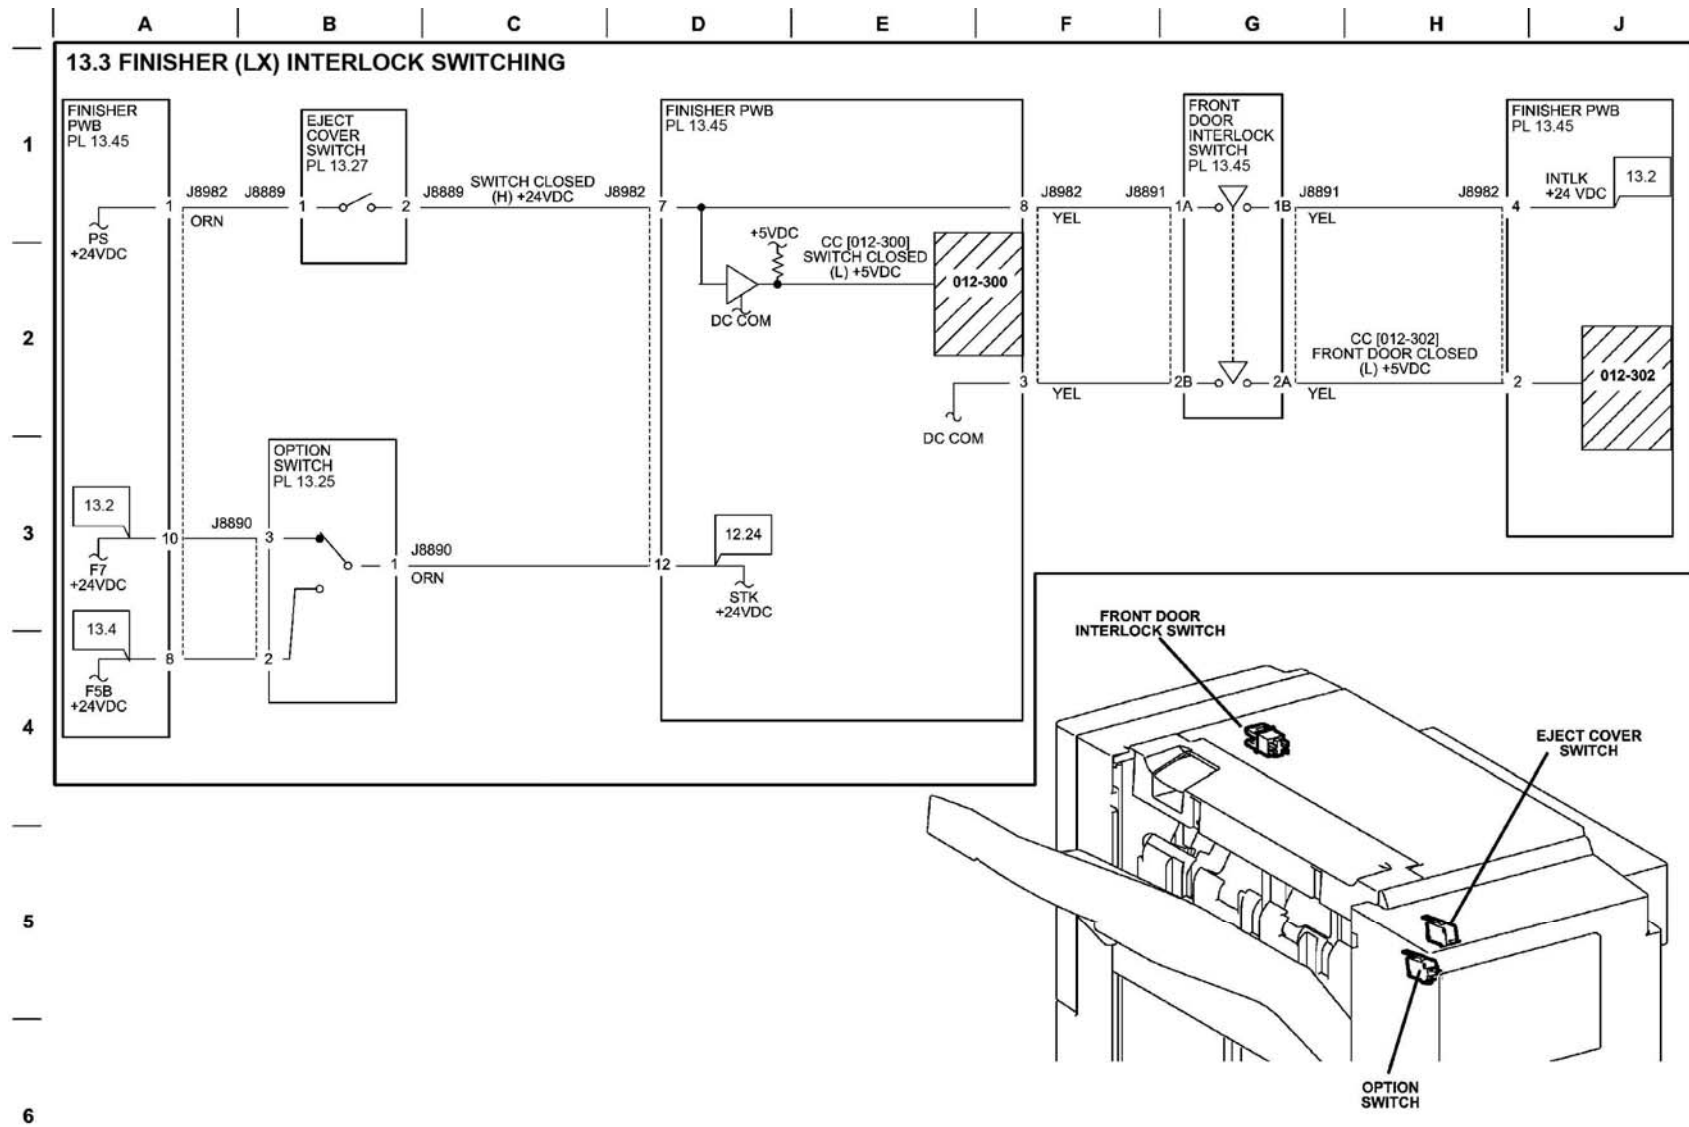
Figure 97 BSD 13.3

BSD 13.3 Office Finisher LX Interlock Switching

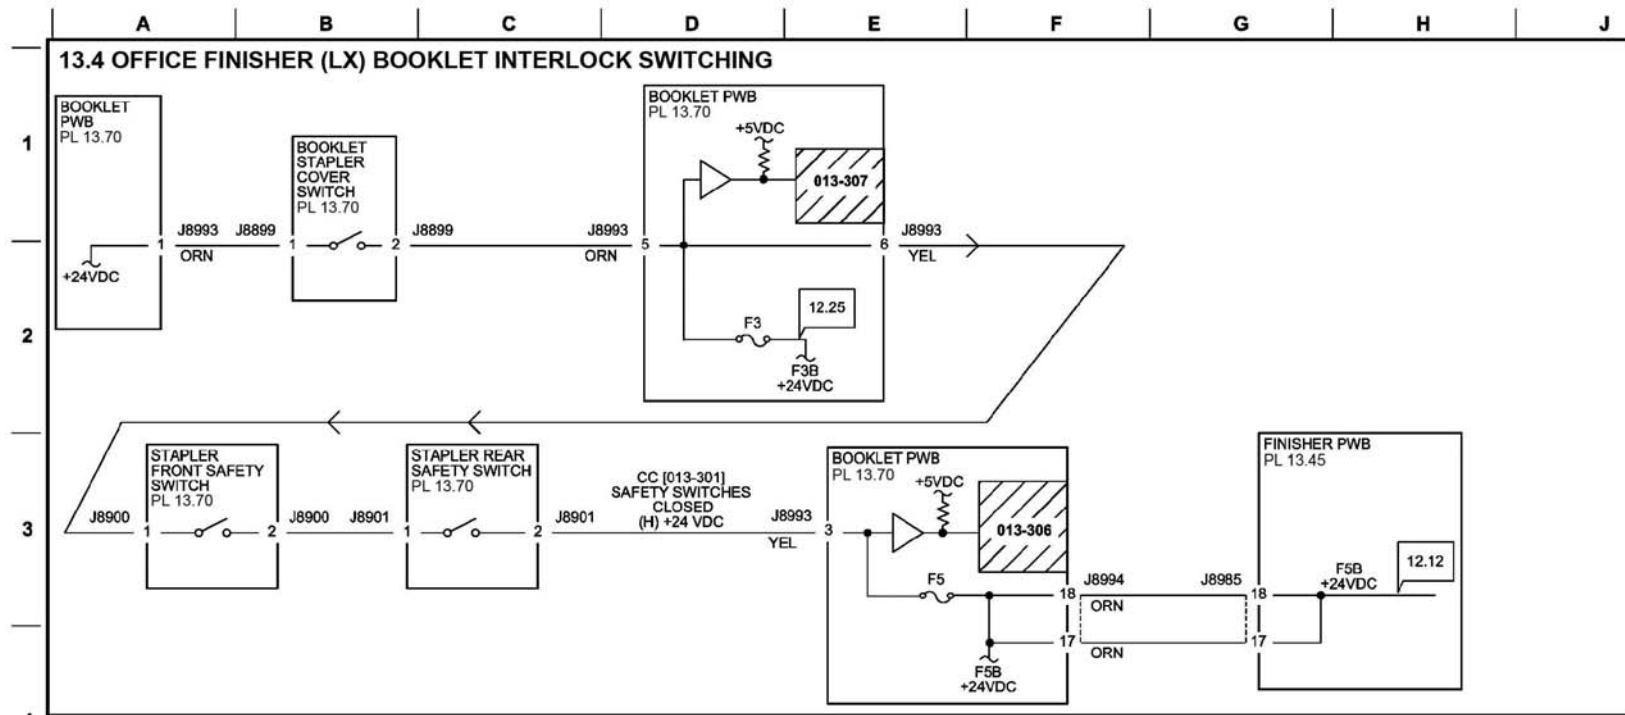
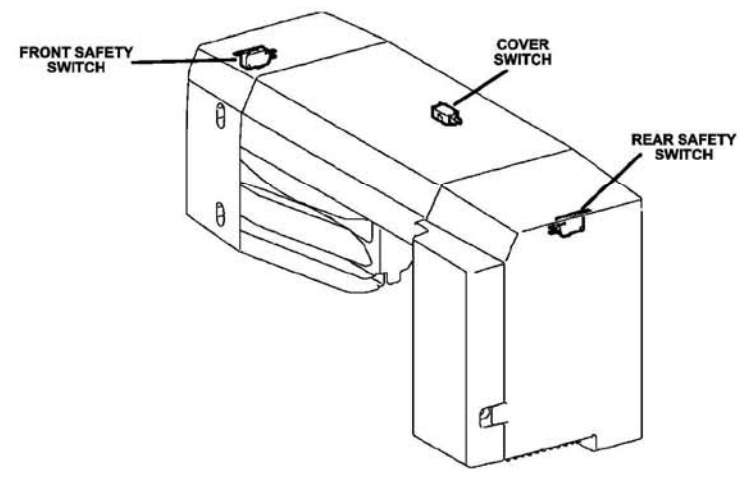
Figure 98 BSD 13.4

BSD 13.4 Office Finisher LX Booklet Interlock Switching

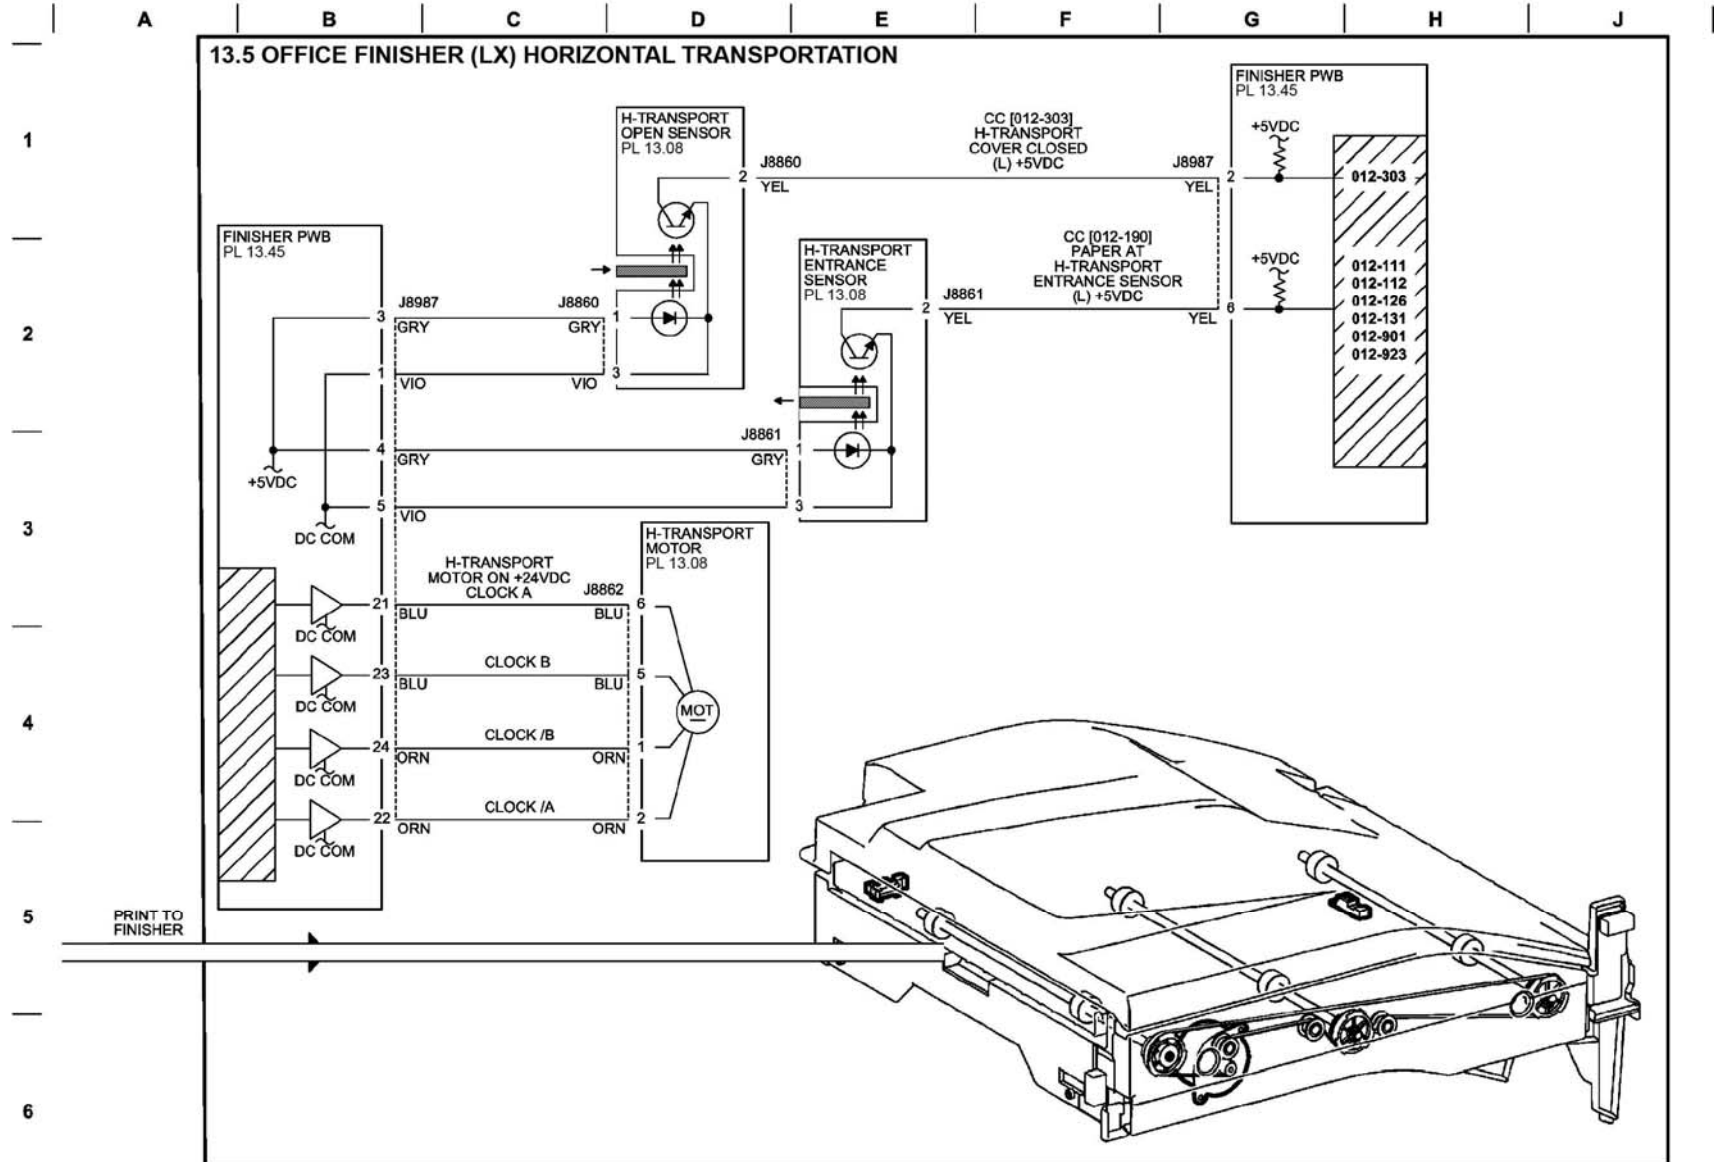
Figure 99 BSD 13.5

BSD 13.5 Office Finisher LX Horizontal Transport

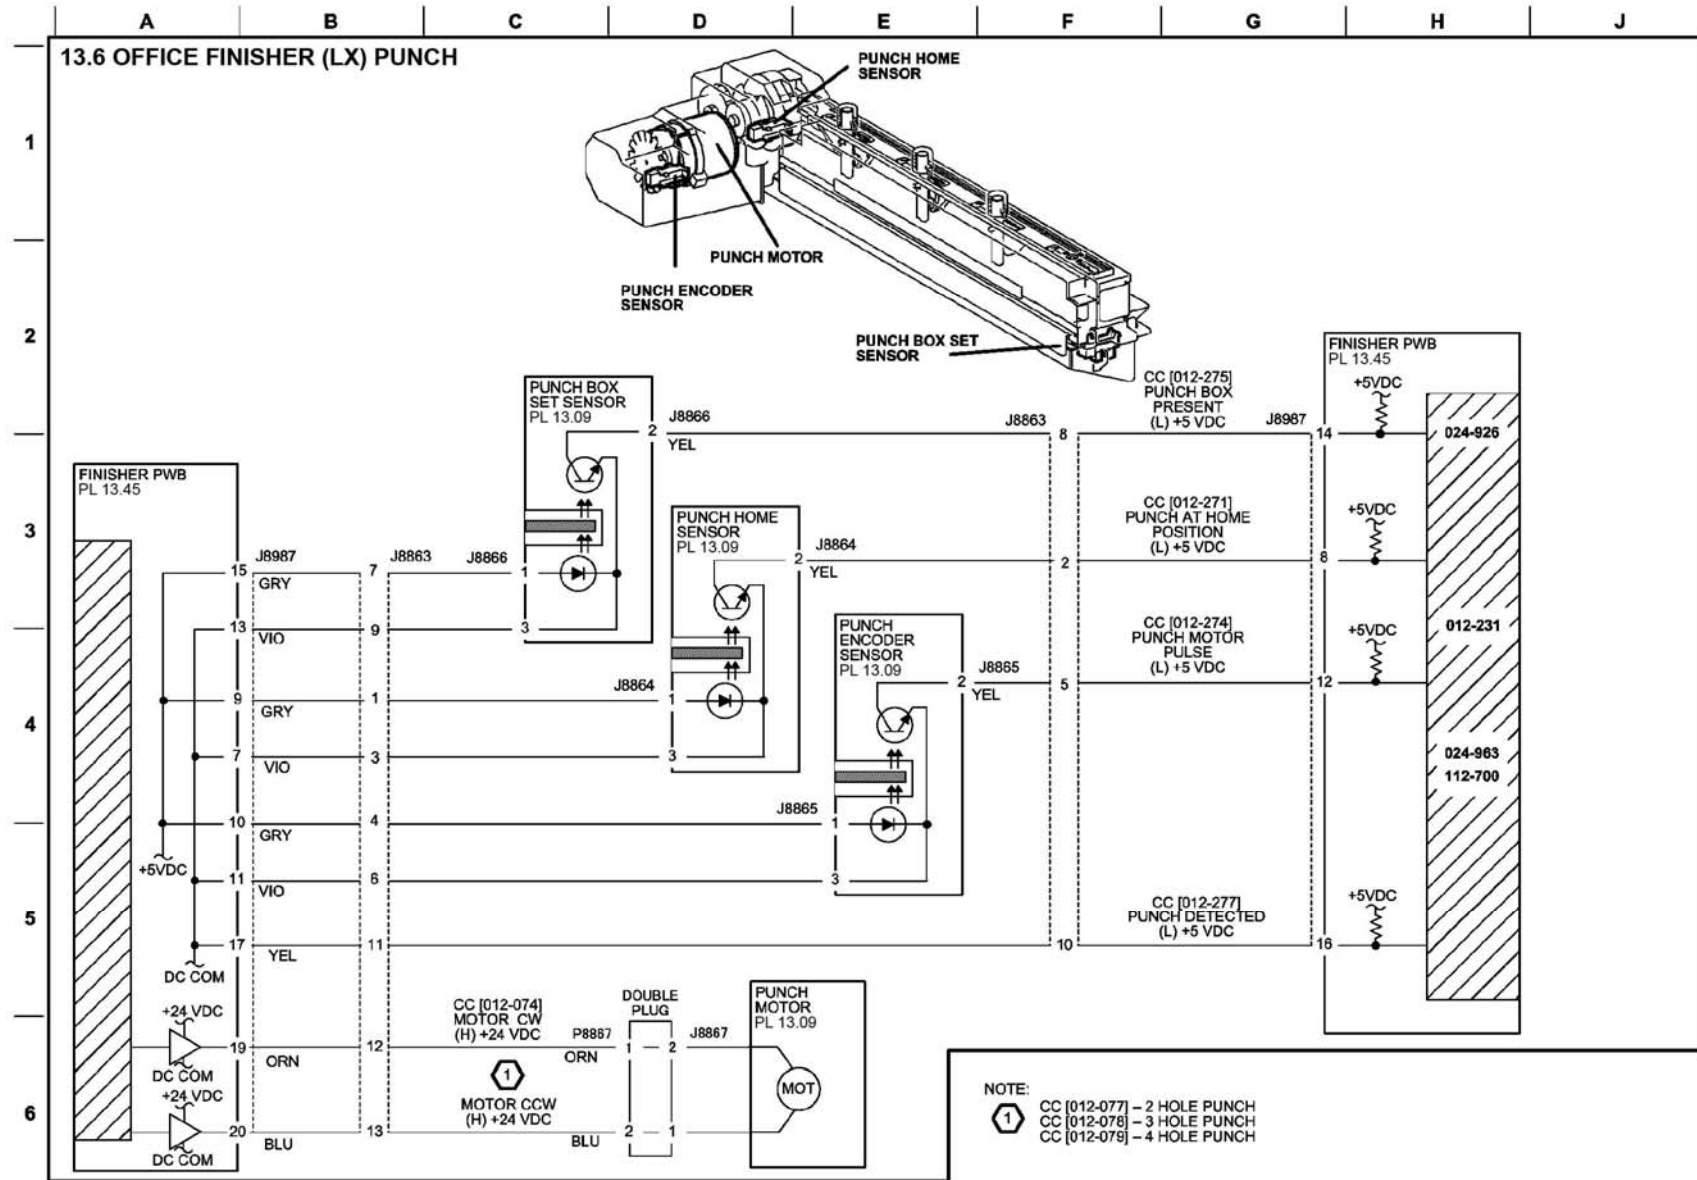
Figure 100 BSD 13.6

BSD 13.6 Office Finisher LX Punch

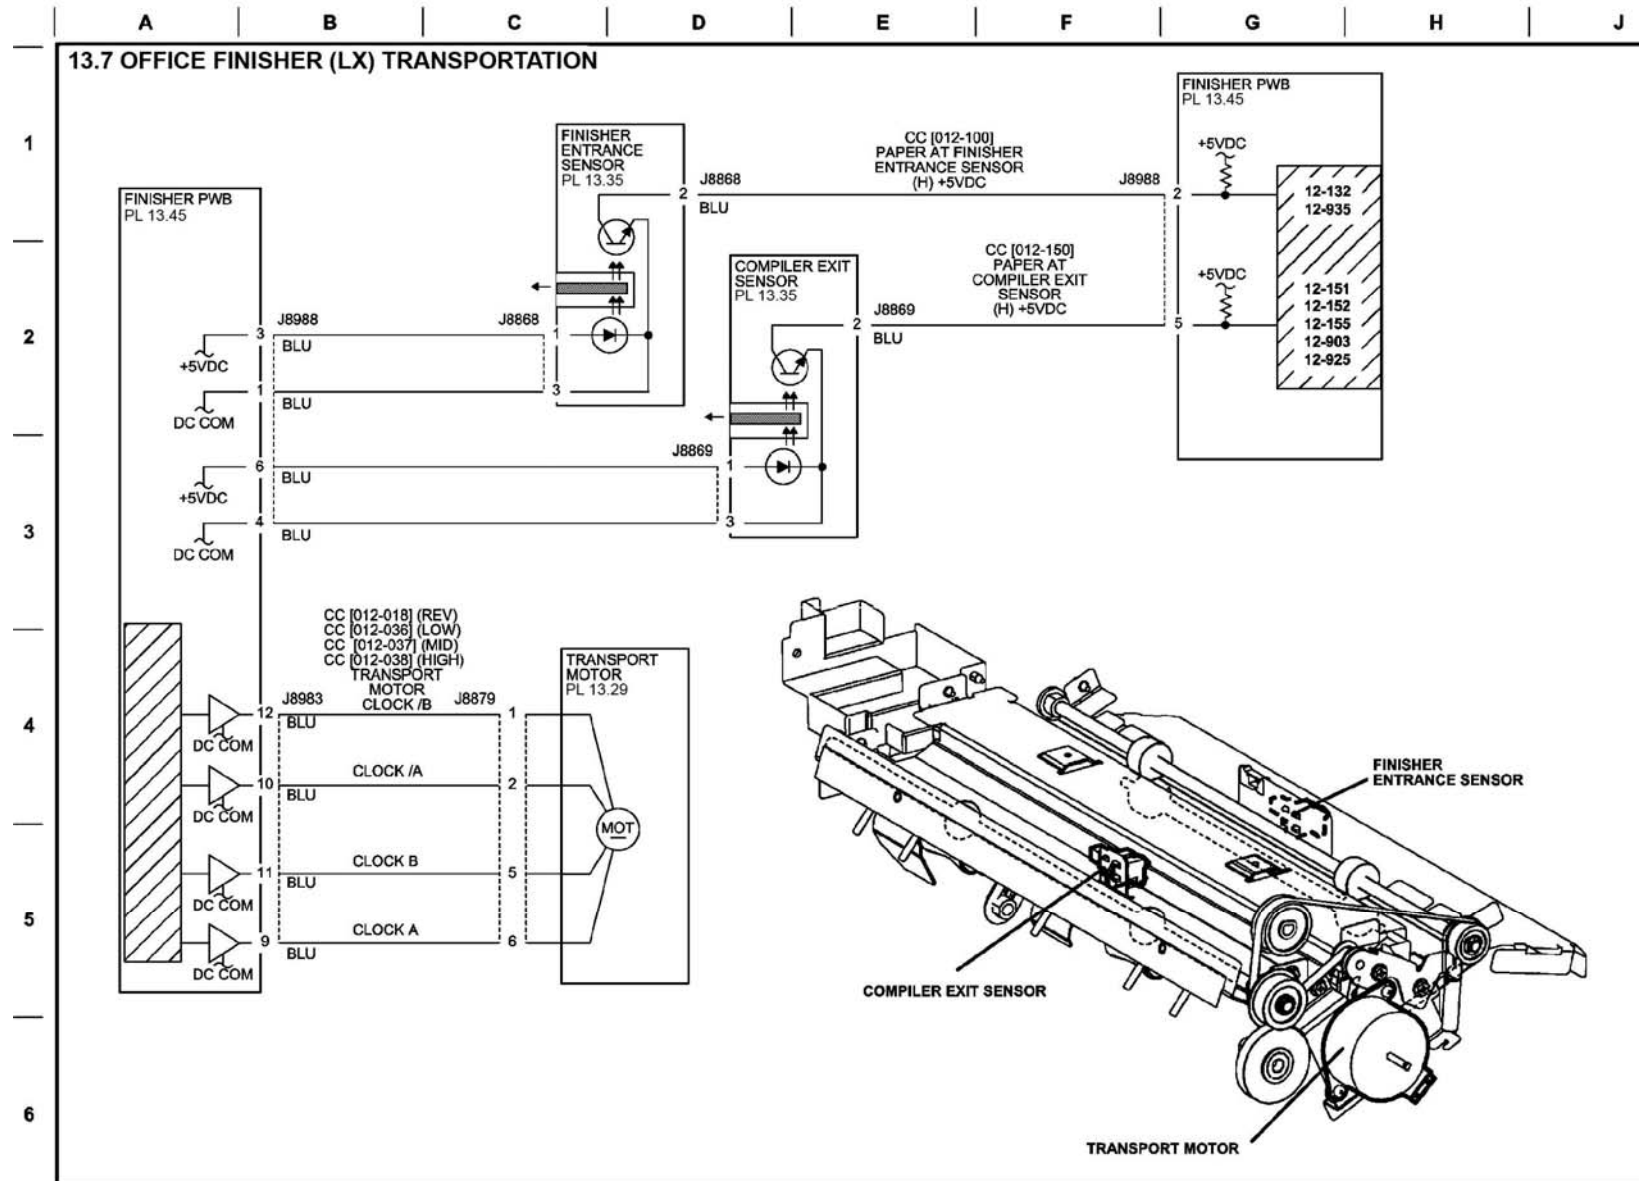
Figure 101 BSD 13.7

BSD 13.7 Office Finisher LX Transportation

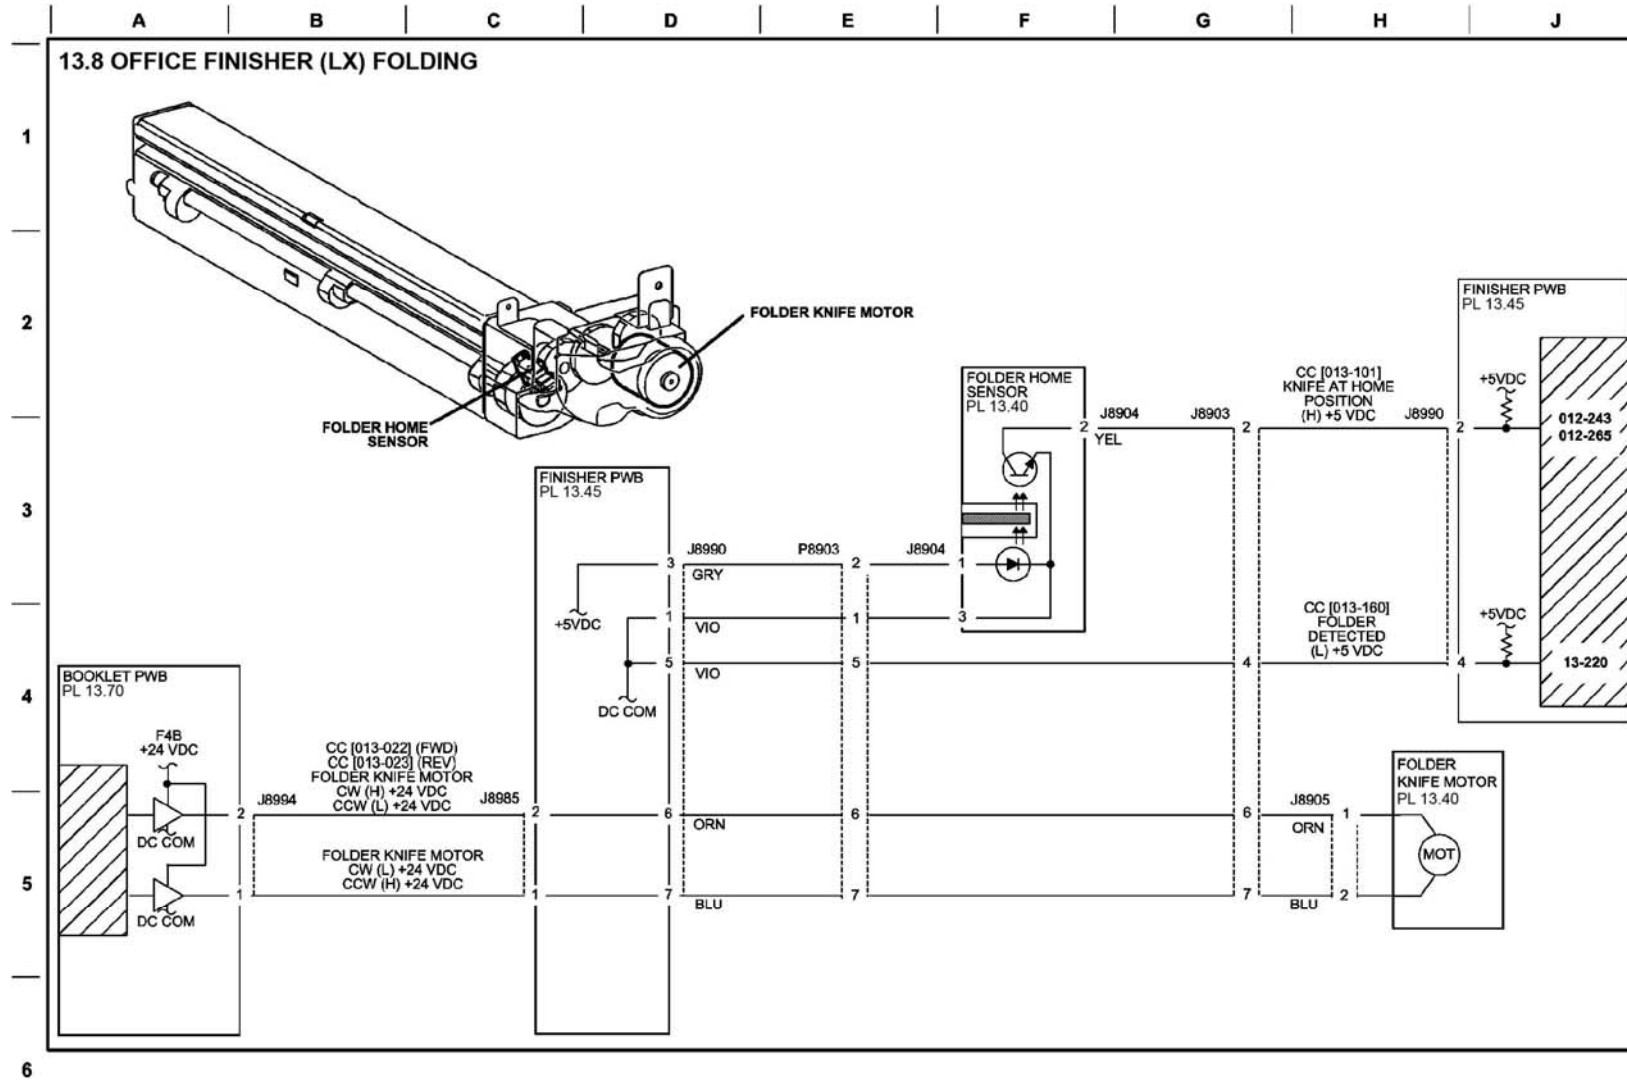
Figure 102 BSD 13.8

BSD 13.8 Office Finisher LX Folding

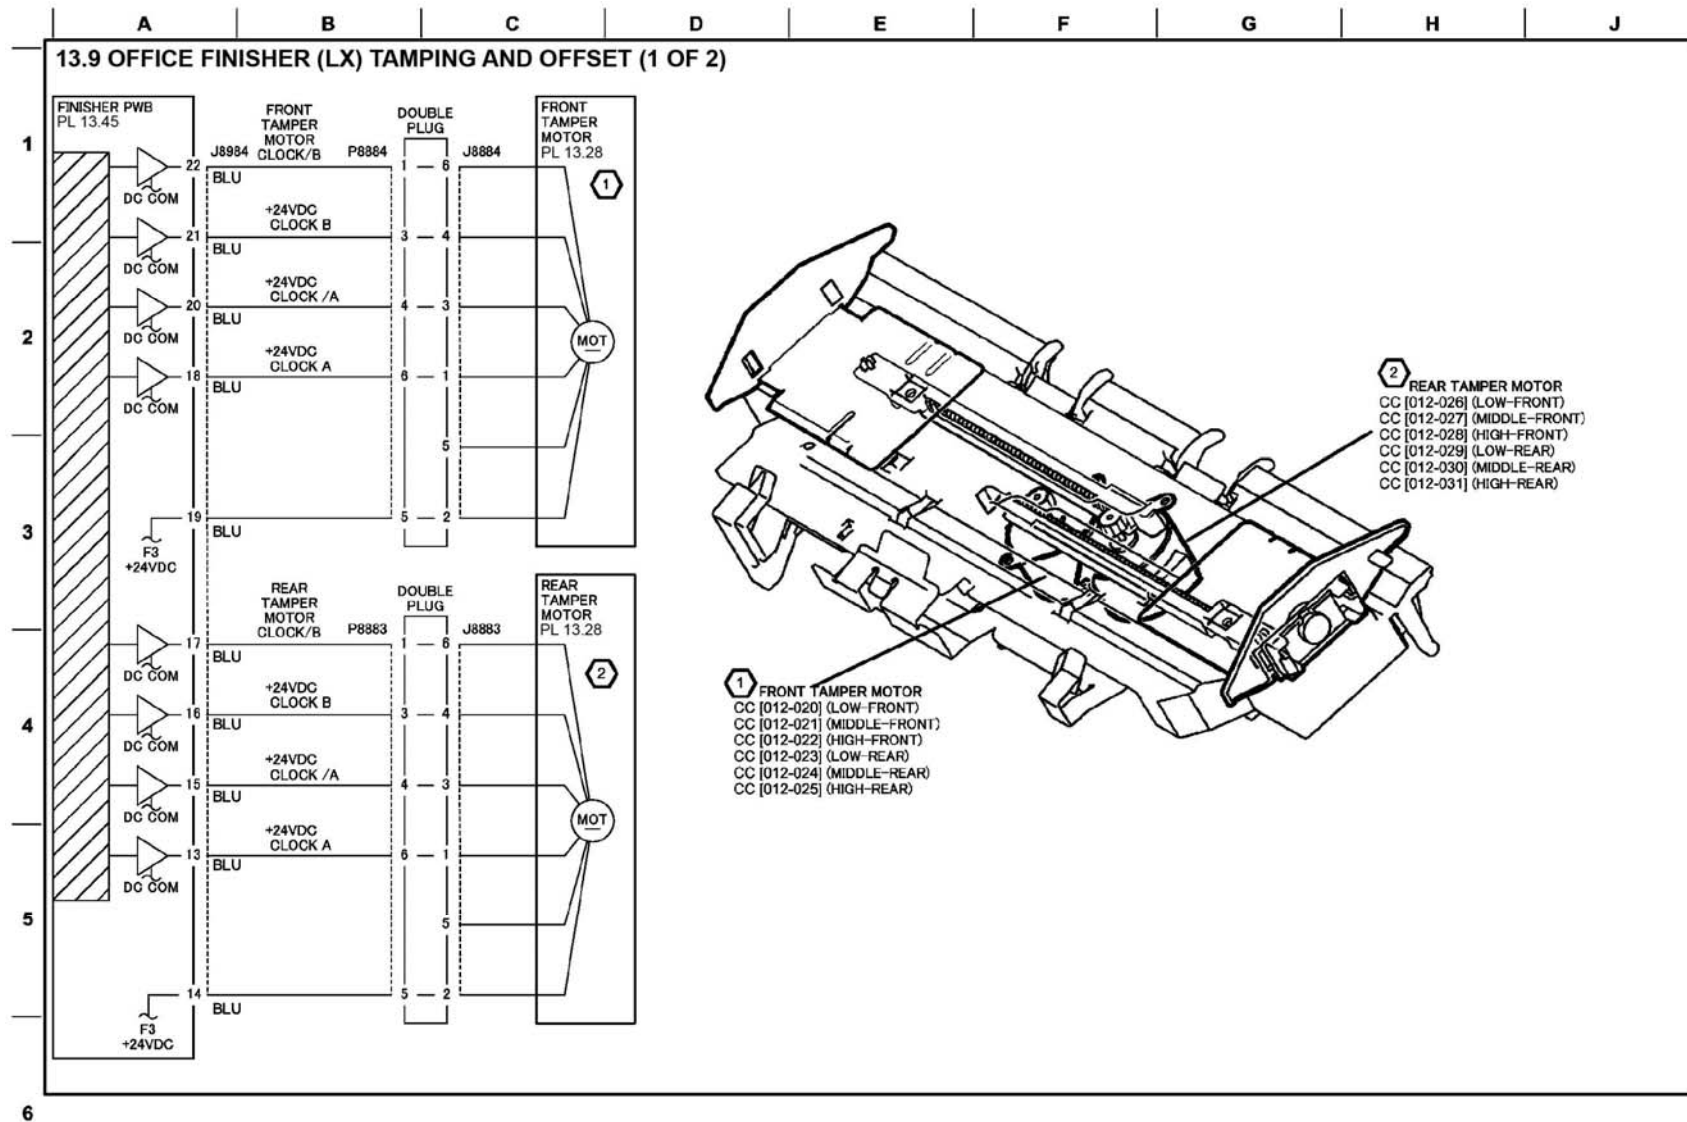
Figure 103 BSD 13.9

BSD 13.9 Office Finisher LX Tamping and Offset (1 of 2)

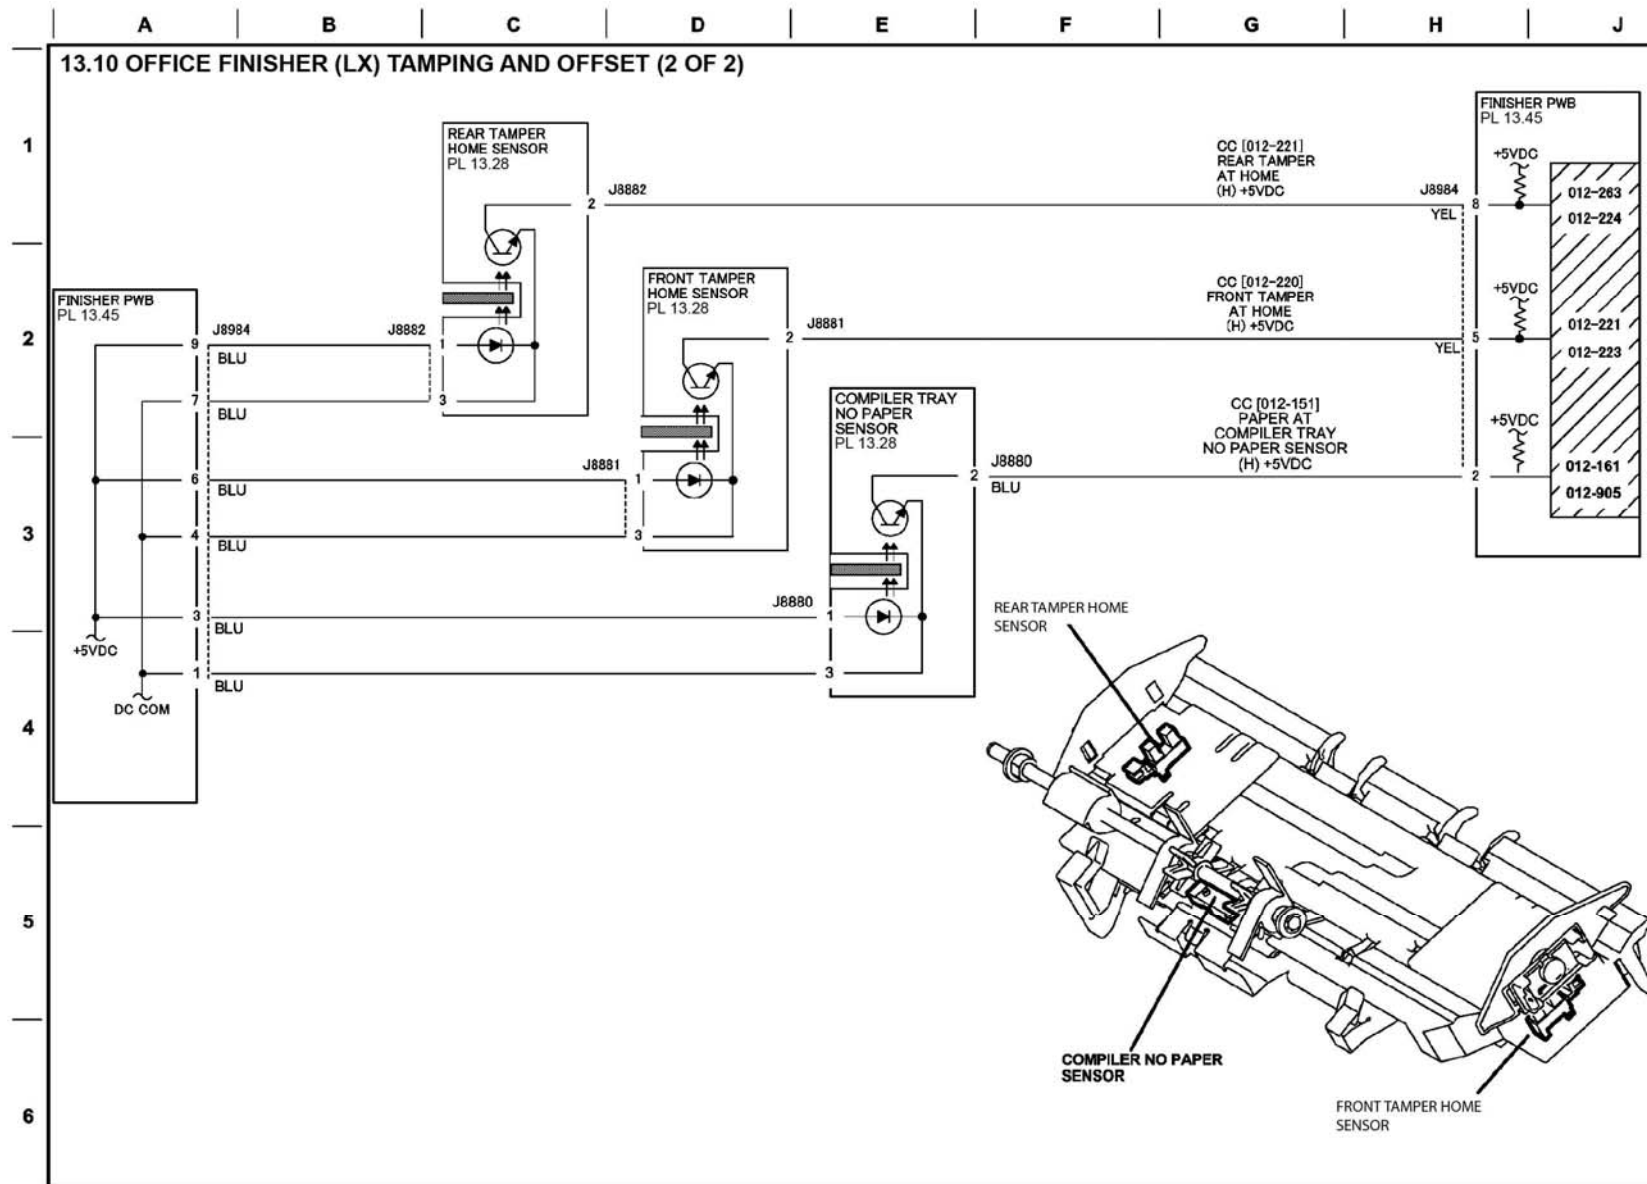
Figure 104 BSD 13.10

BSD 13.10 Office Finisher LX Tamping and Offset (2 of 2)

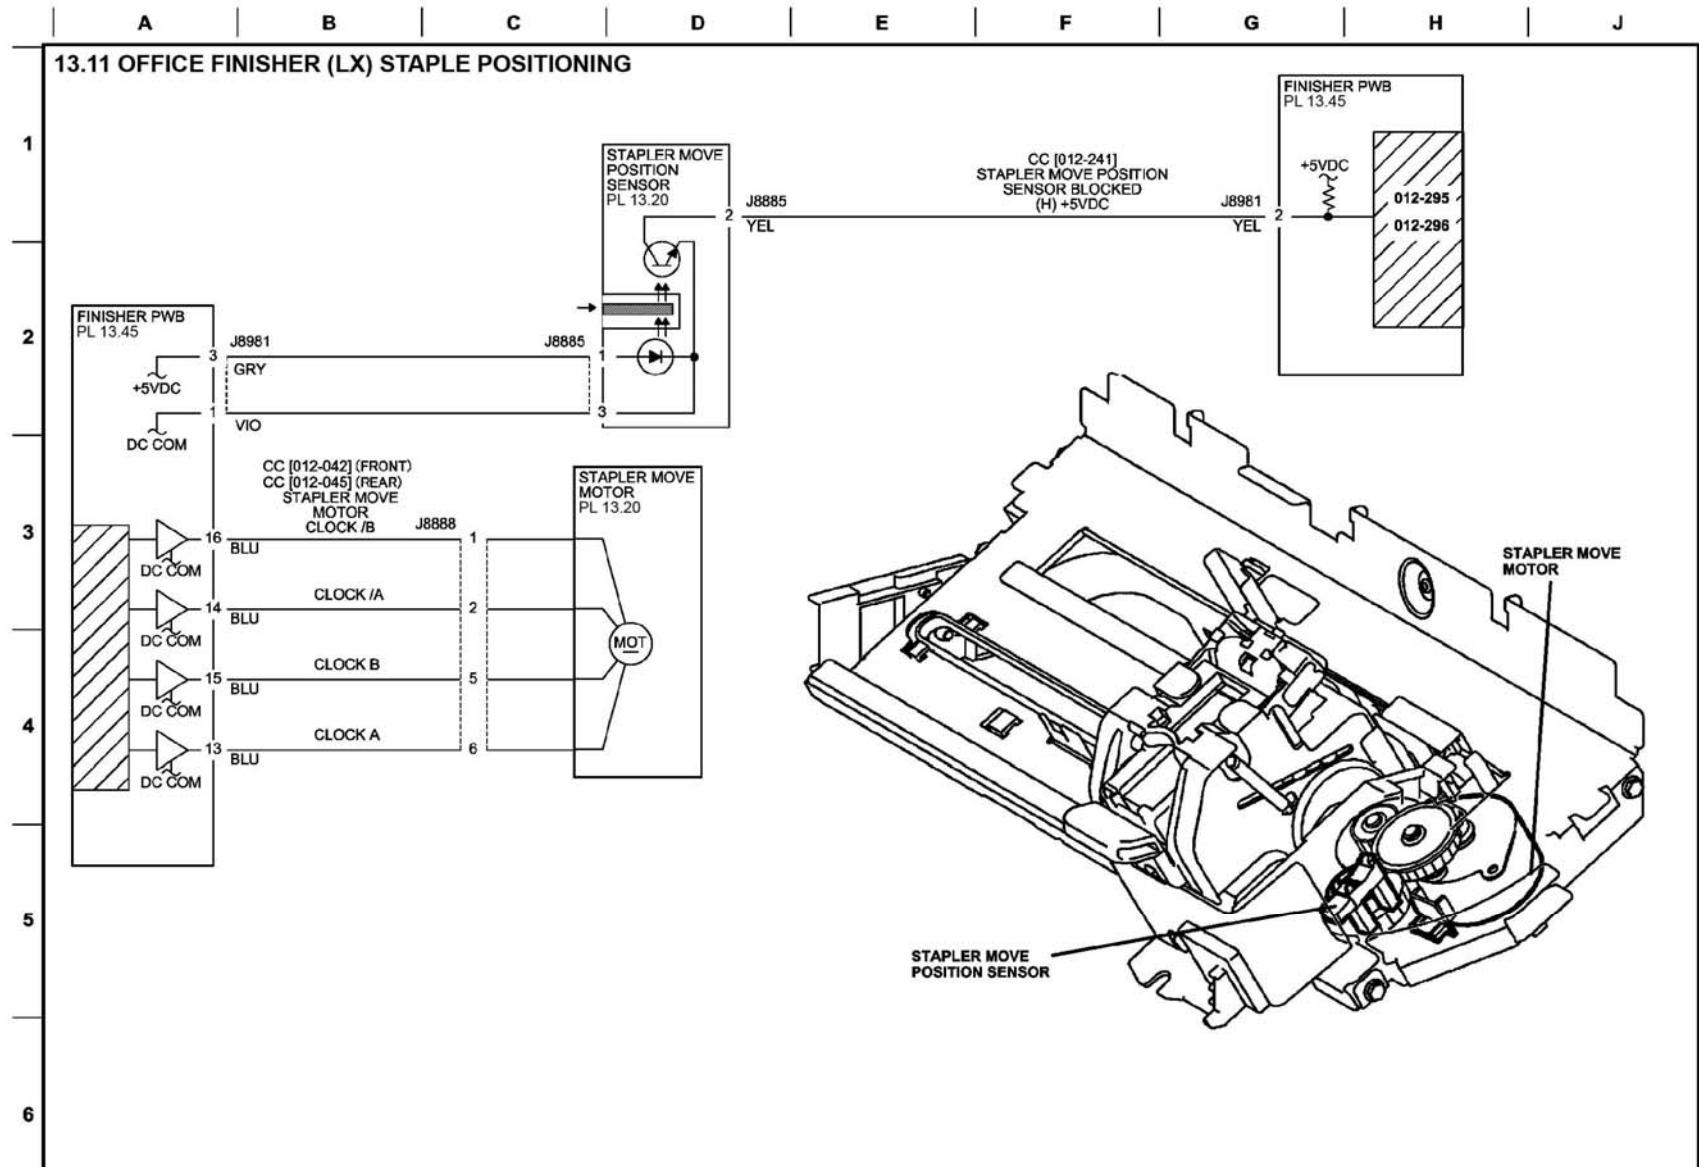
Figure 105 BSD 13.11

BSD 13.11 Office Finisher LX Staple Positioning
