708P91370
April 2017

Xerox® VersaLink® B7025/B7030/B7035 Multifunction Printer Service Manual

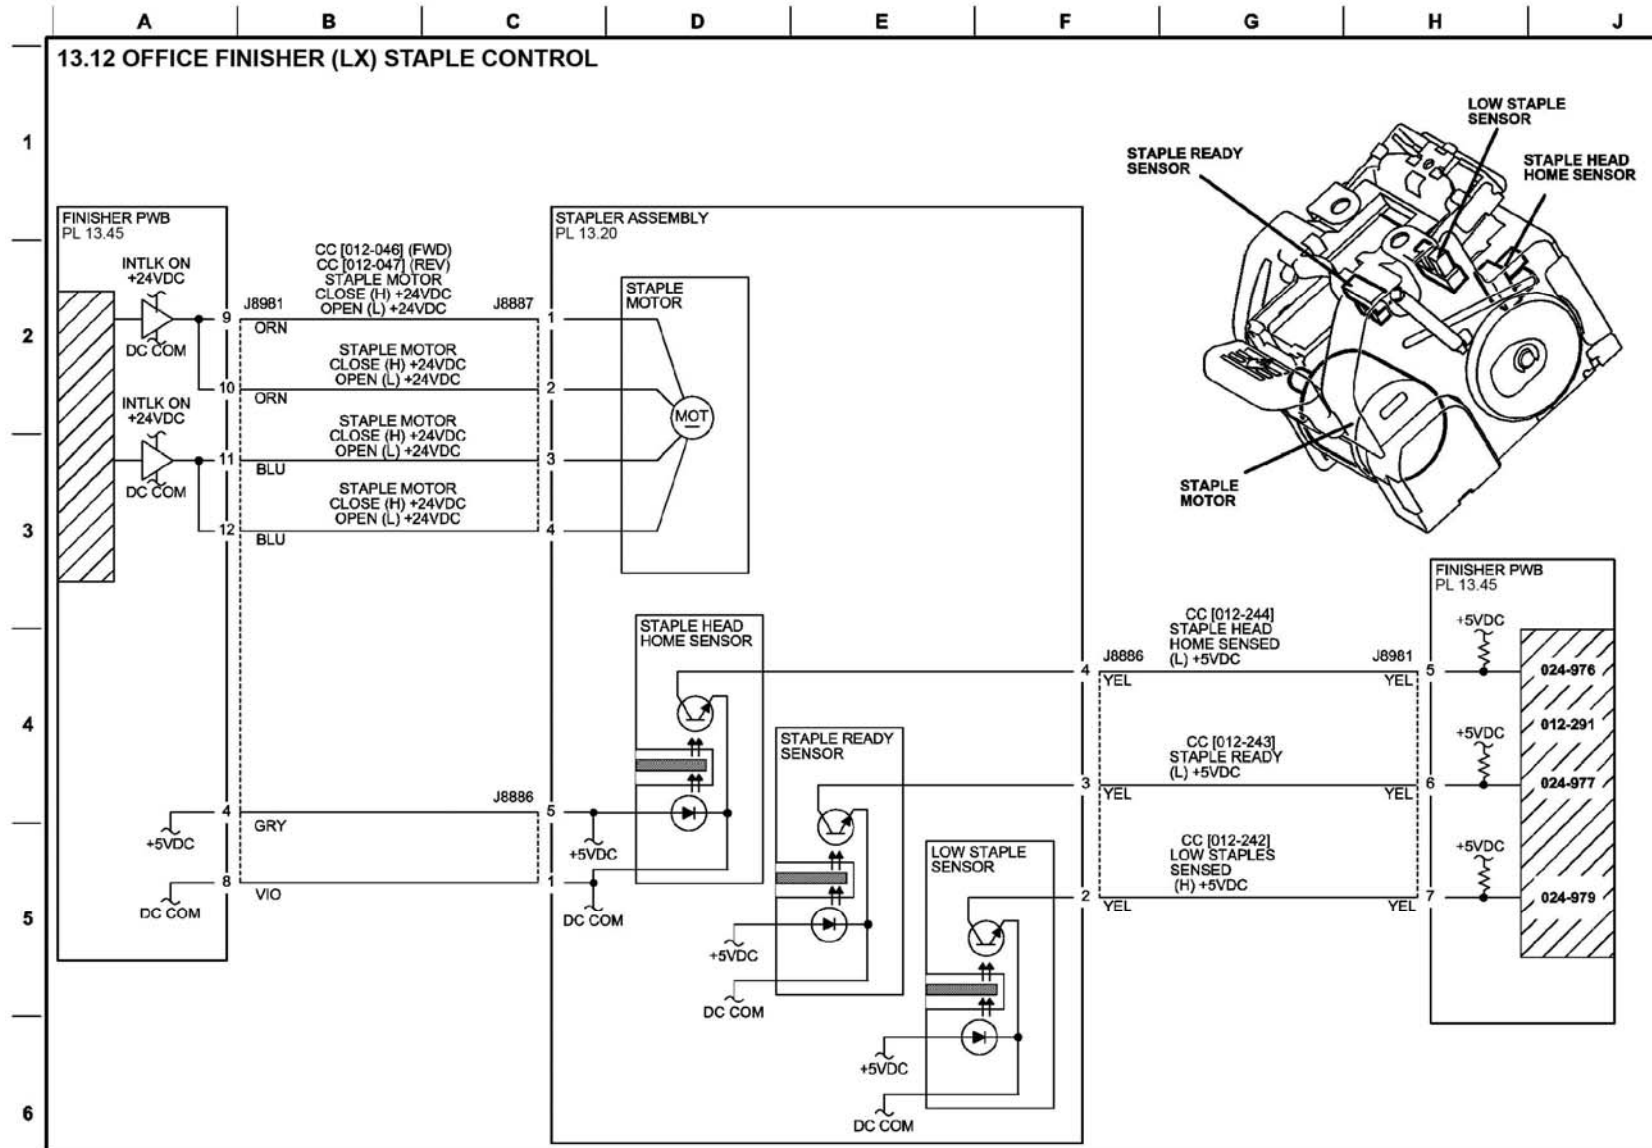
Figure 106 BSD 13.12

BSD 13.12 Office Finisher LX Staple Control

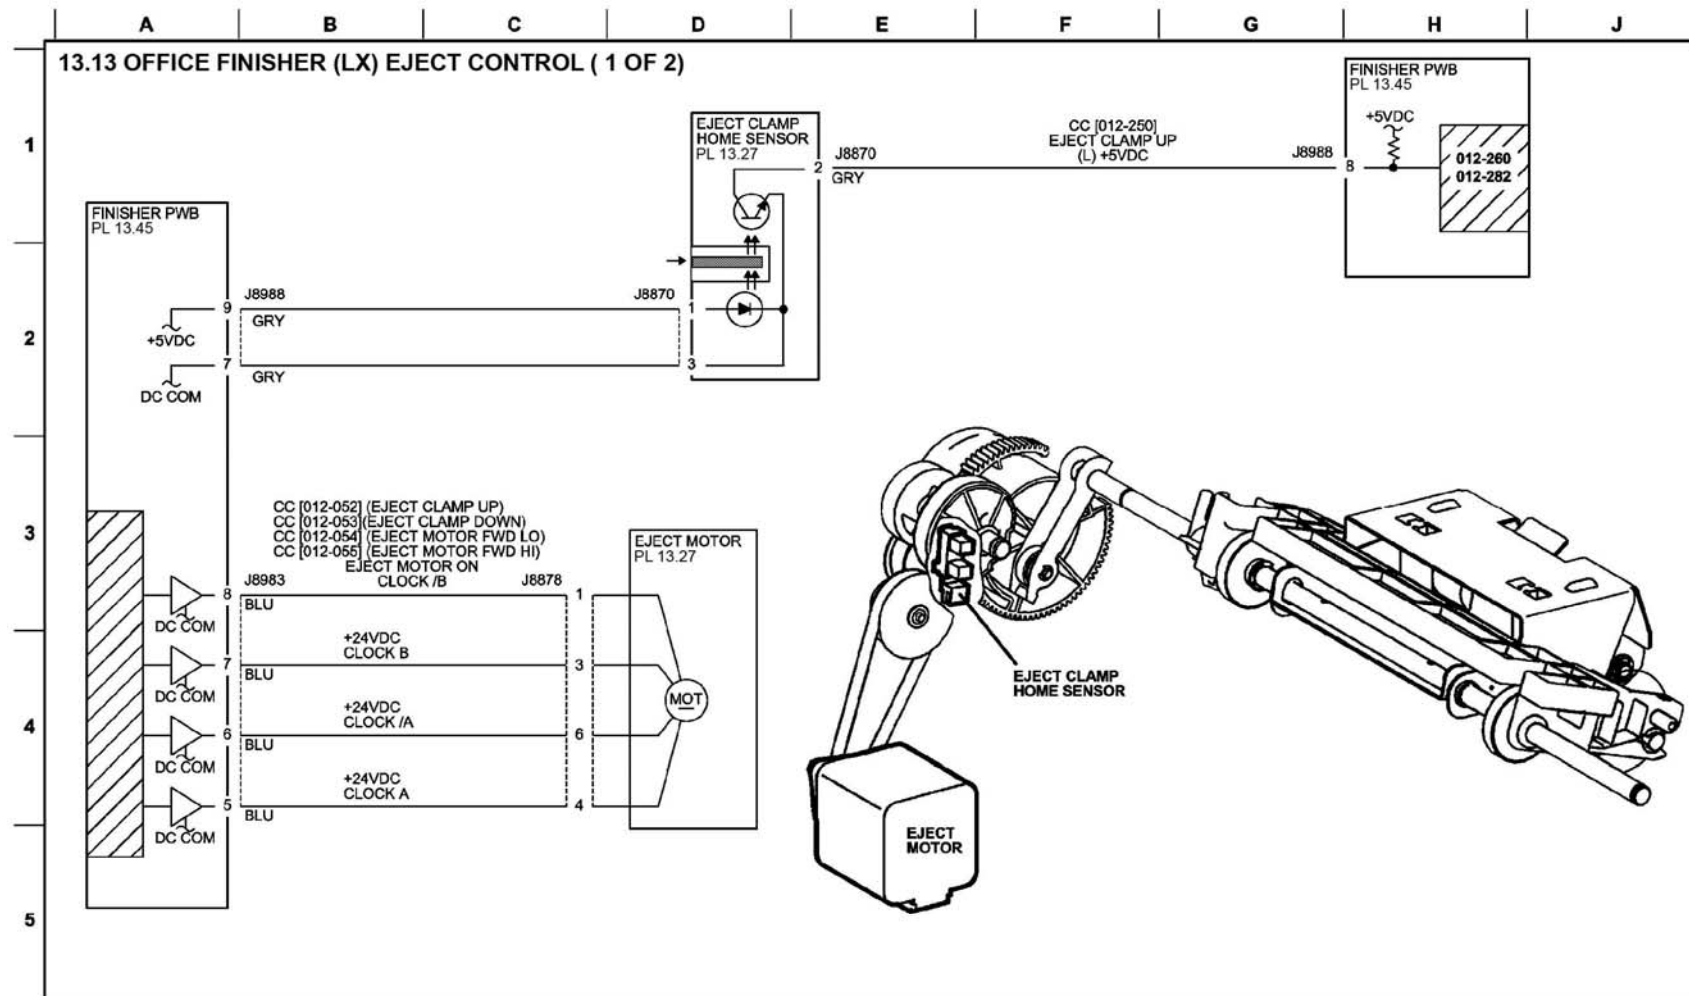
Figure 107 BSD 13.13

BSD 13.13 Office Finisher LX Eject Control (1 of 2)

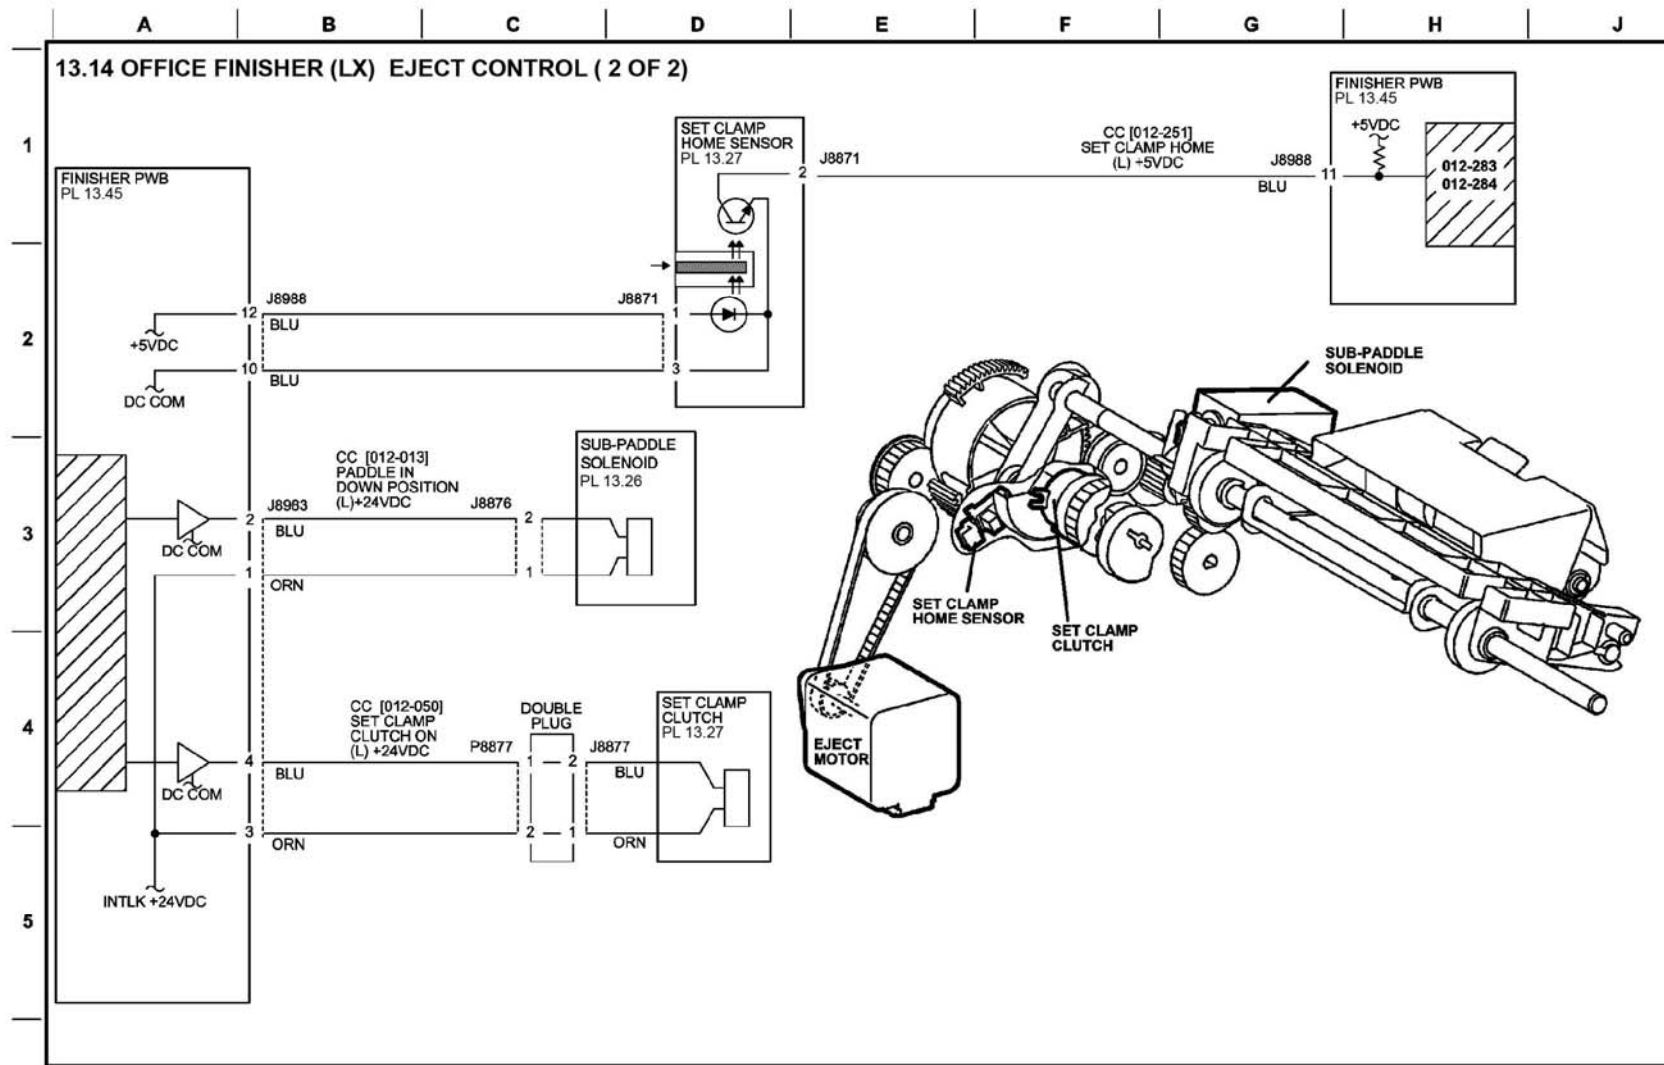
Figure 108 BSD 13.14

BSD 13.14 Office Finisher LX Eject Control (2 of 2)

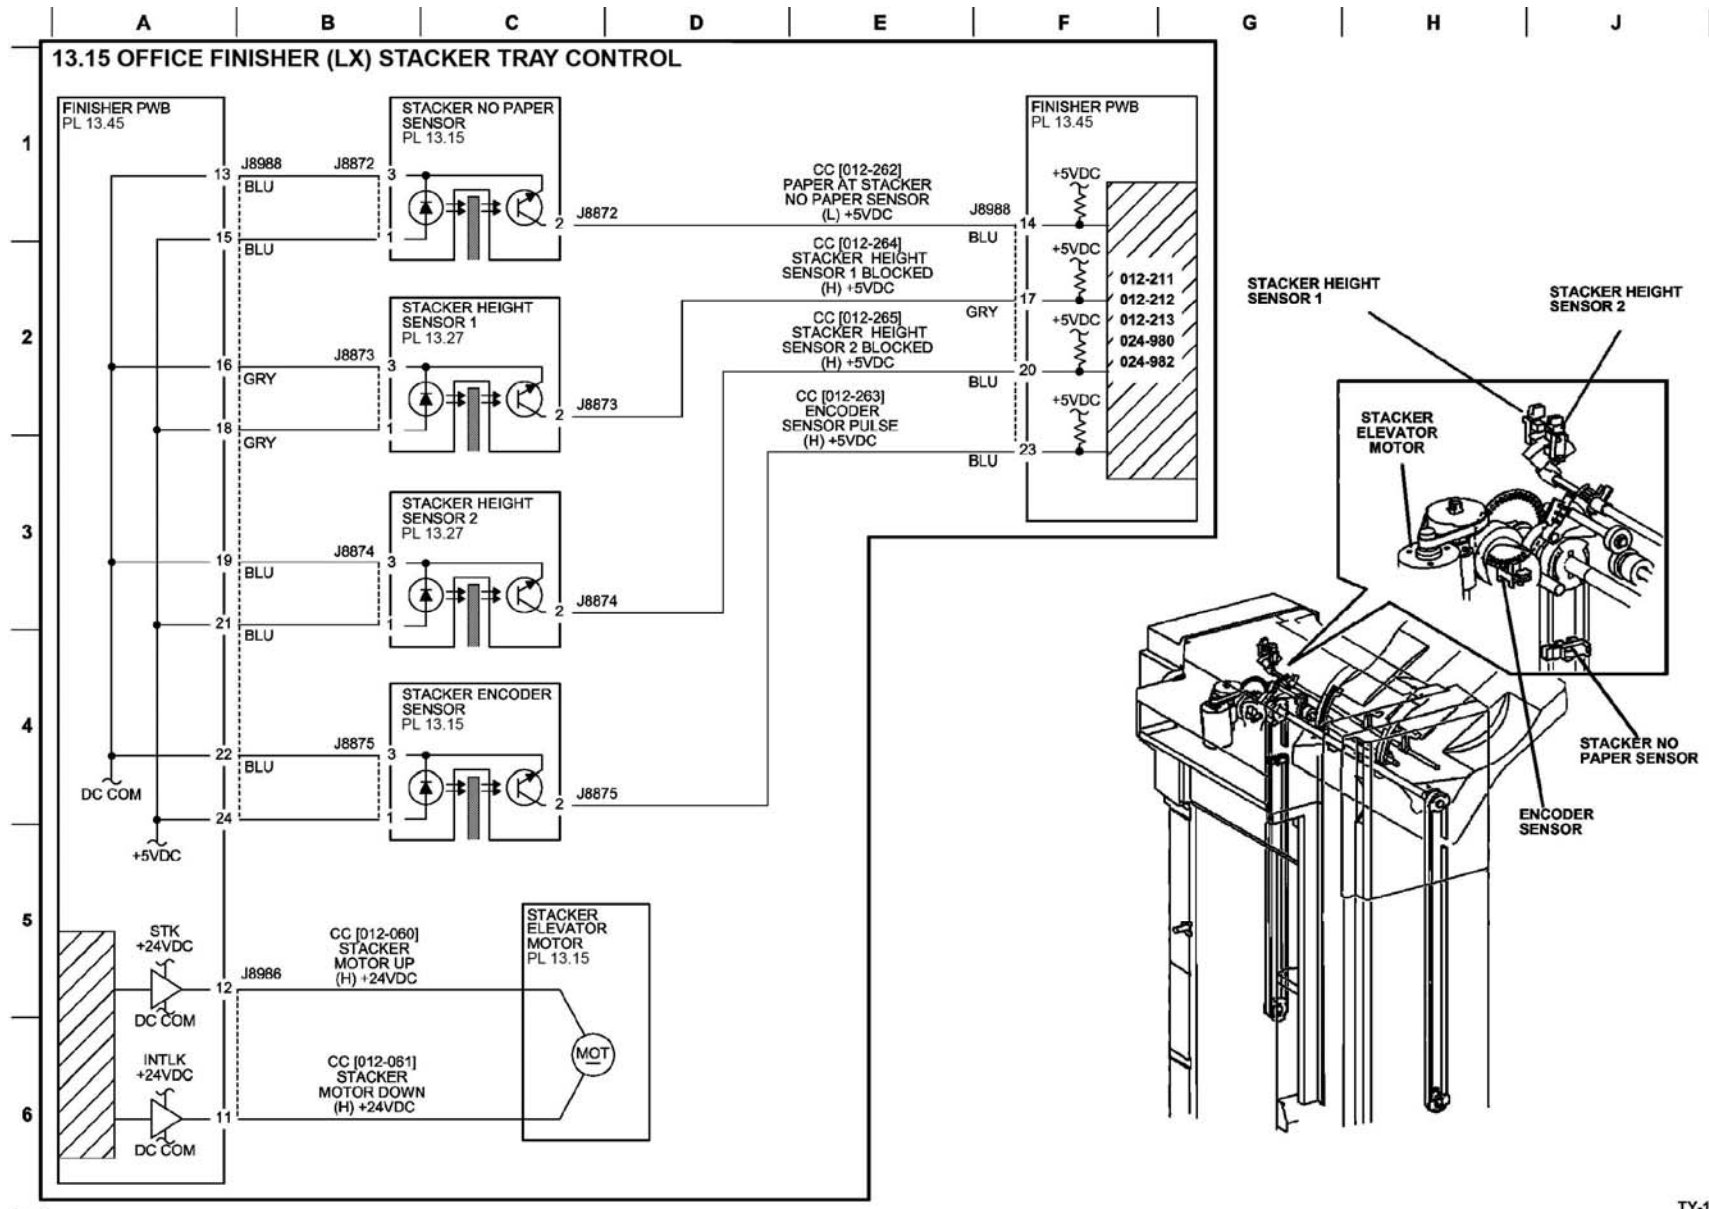
Figure 109 BSD 13.15

BSD 13.15 Office Finisher LX Stacker Tray Control

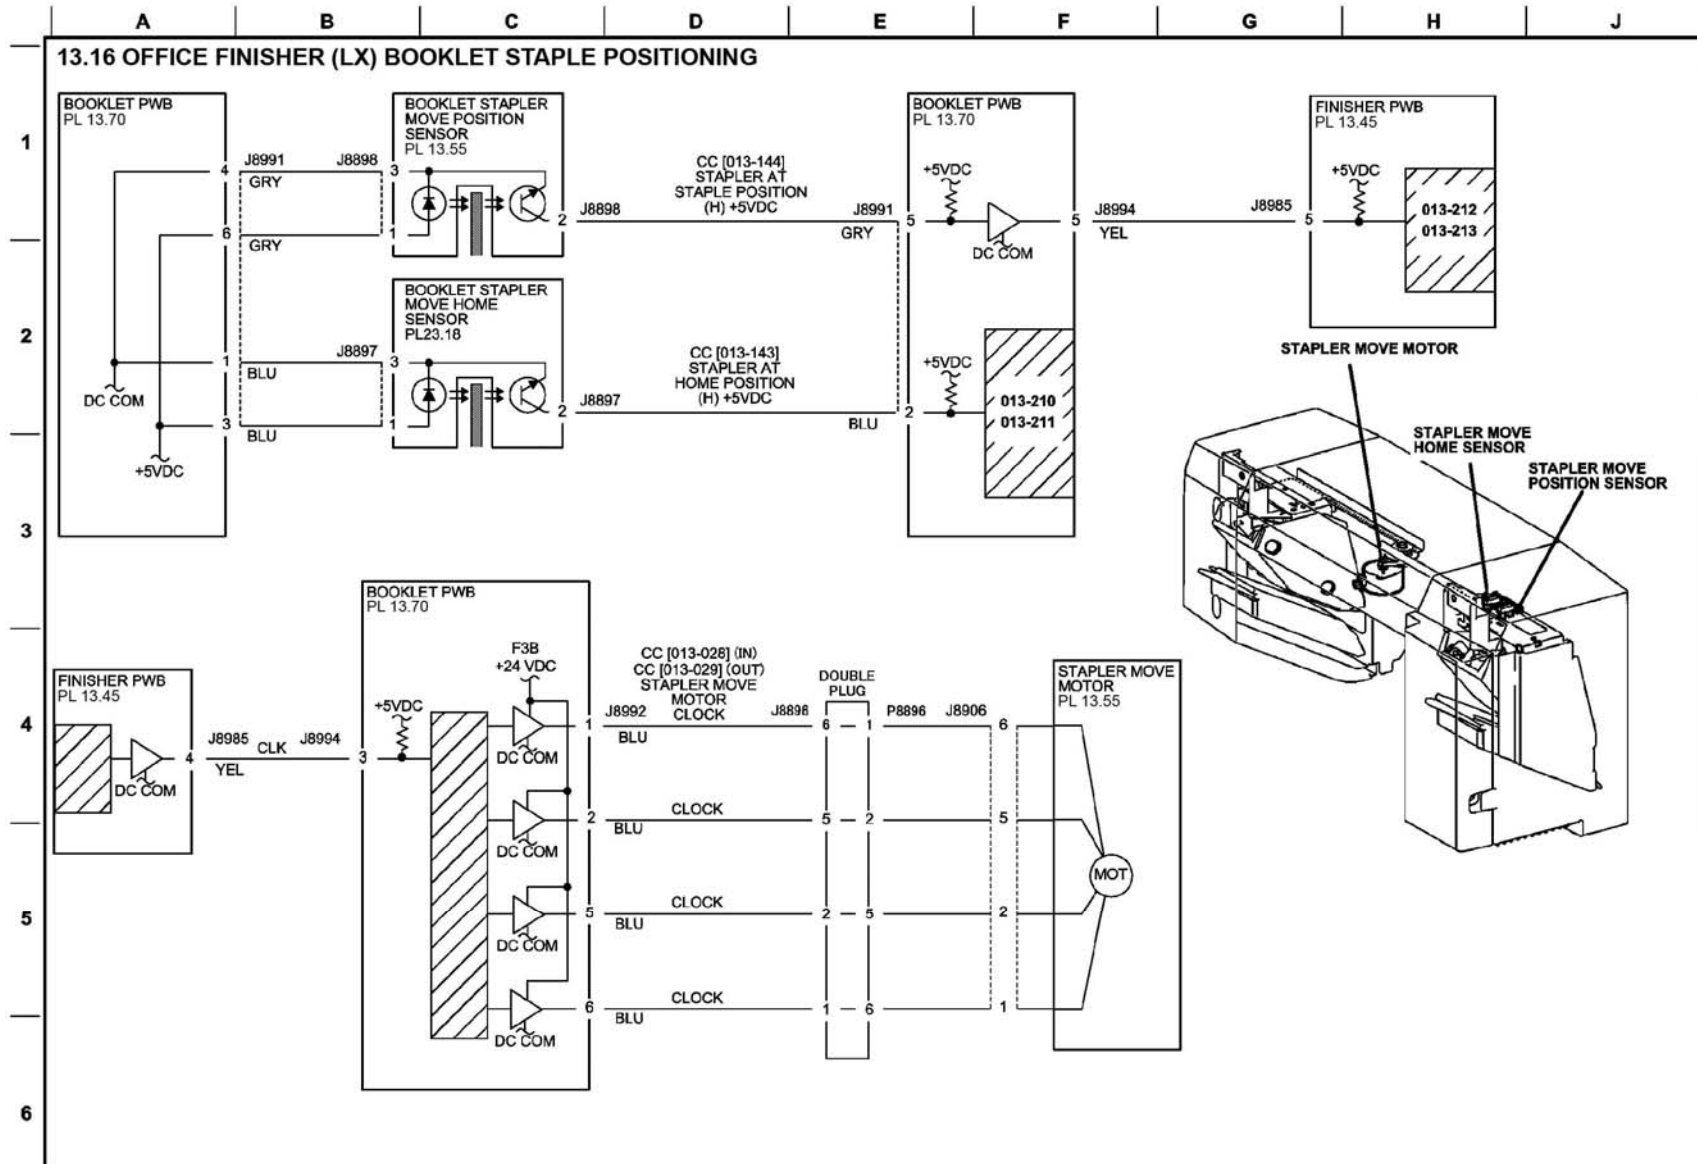
Figure 110 BSD 13.16

BSD 13.16 Office Finisher LX Booklet Staple Positioning

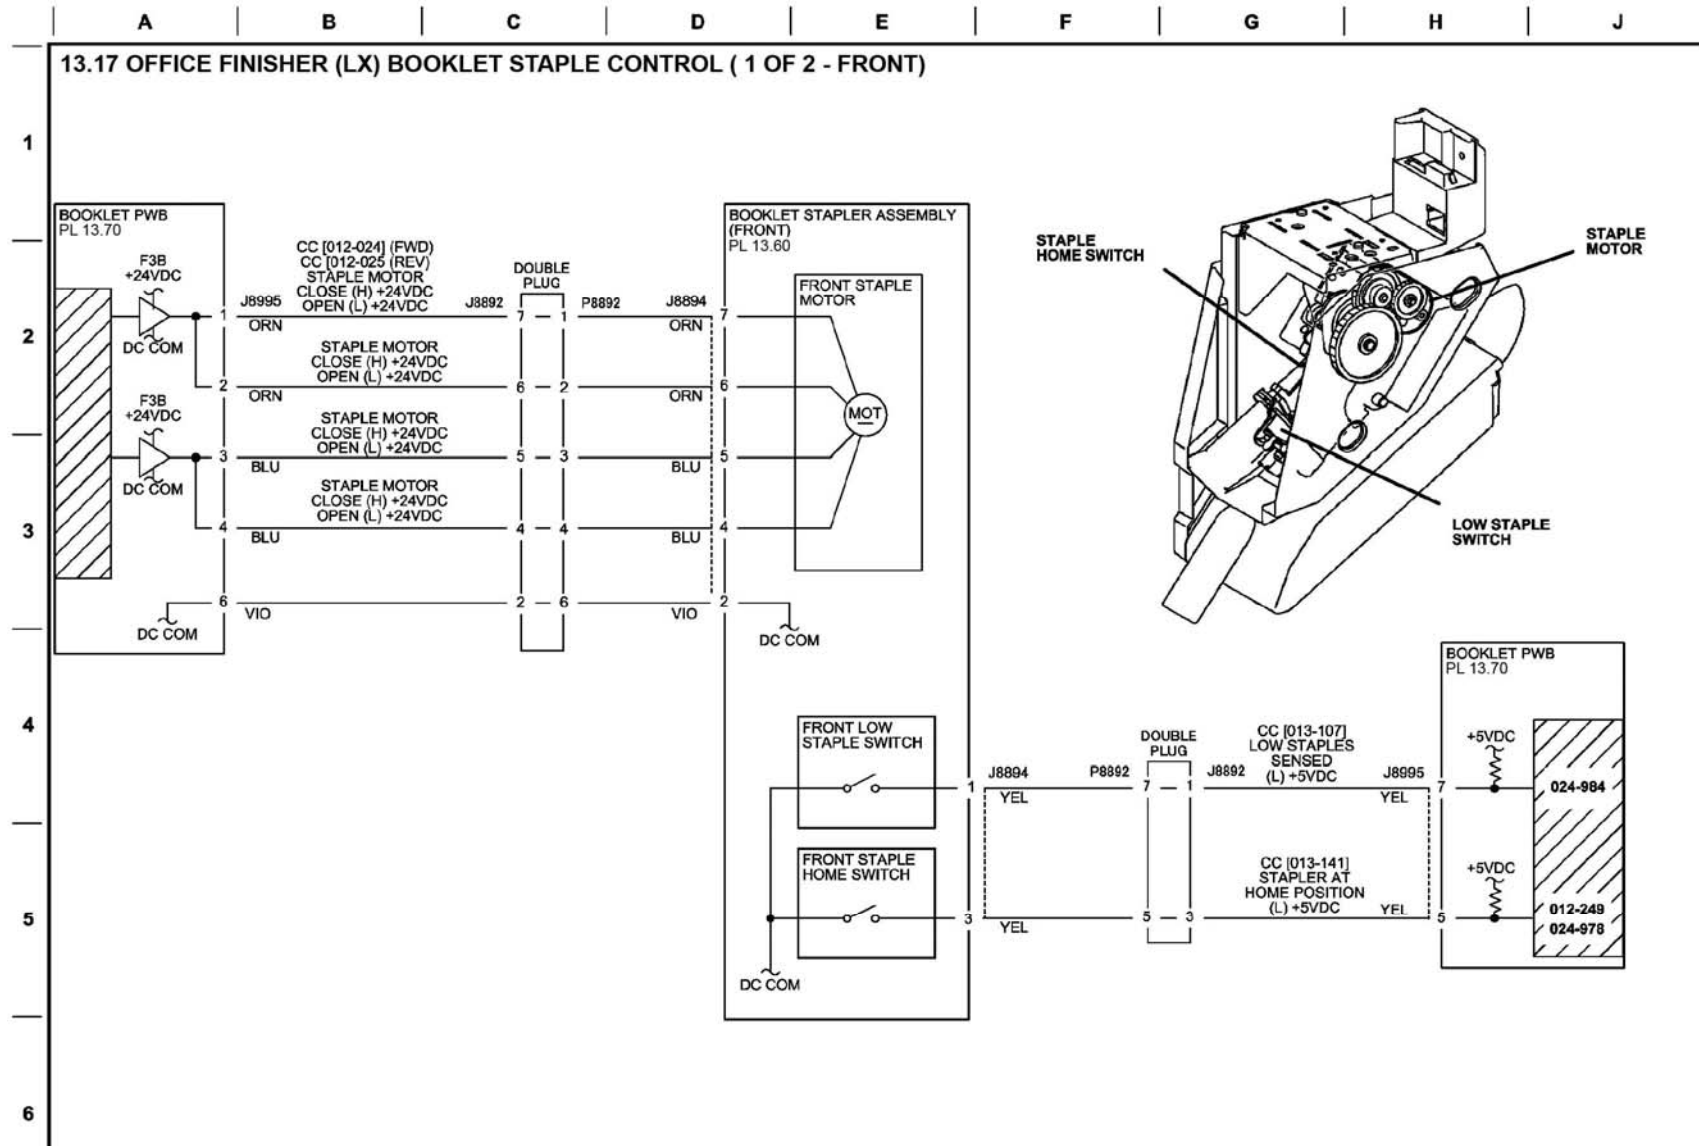
Figure 111 BSD 13.17

BSD 13.17 Office Finisher LX Booklet Staple Control (1 of 2 - Front)

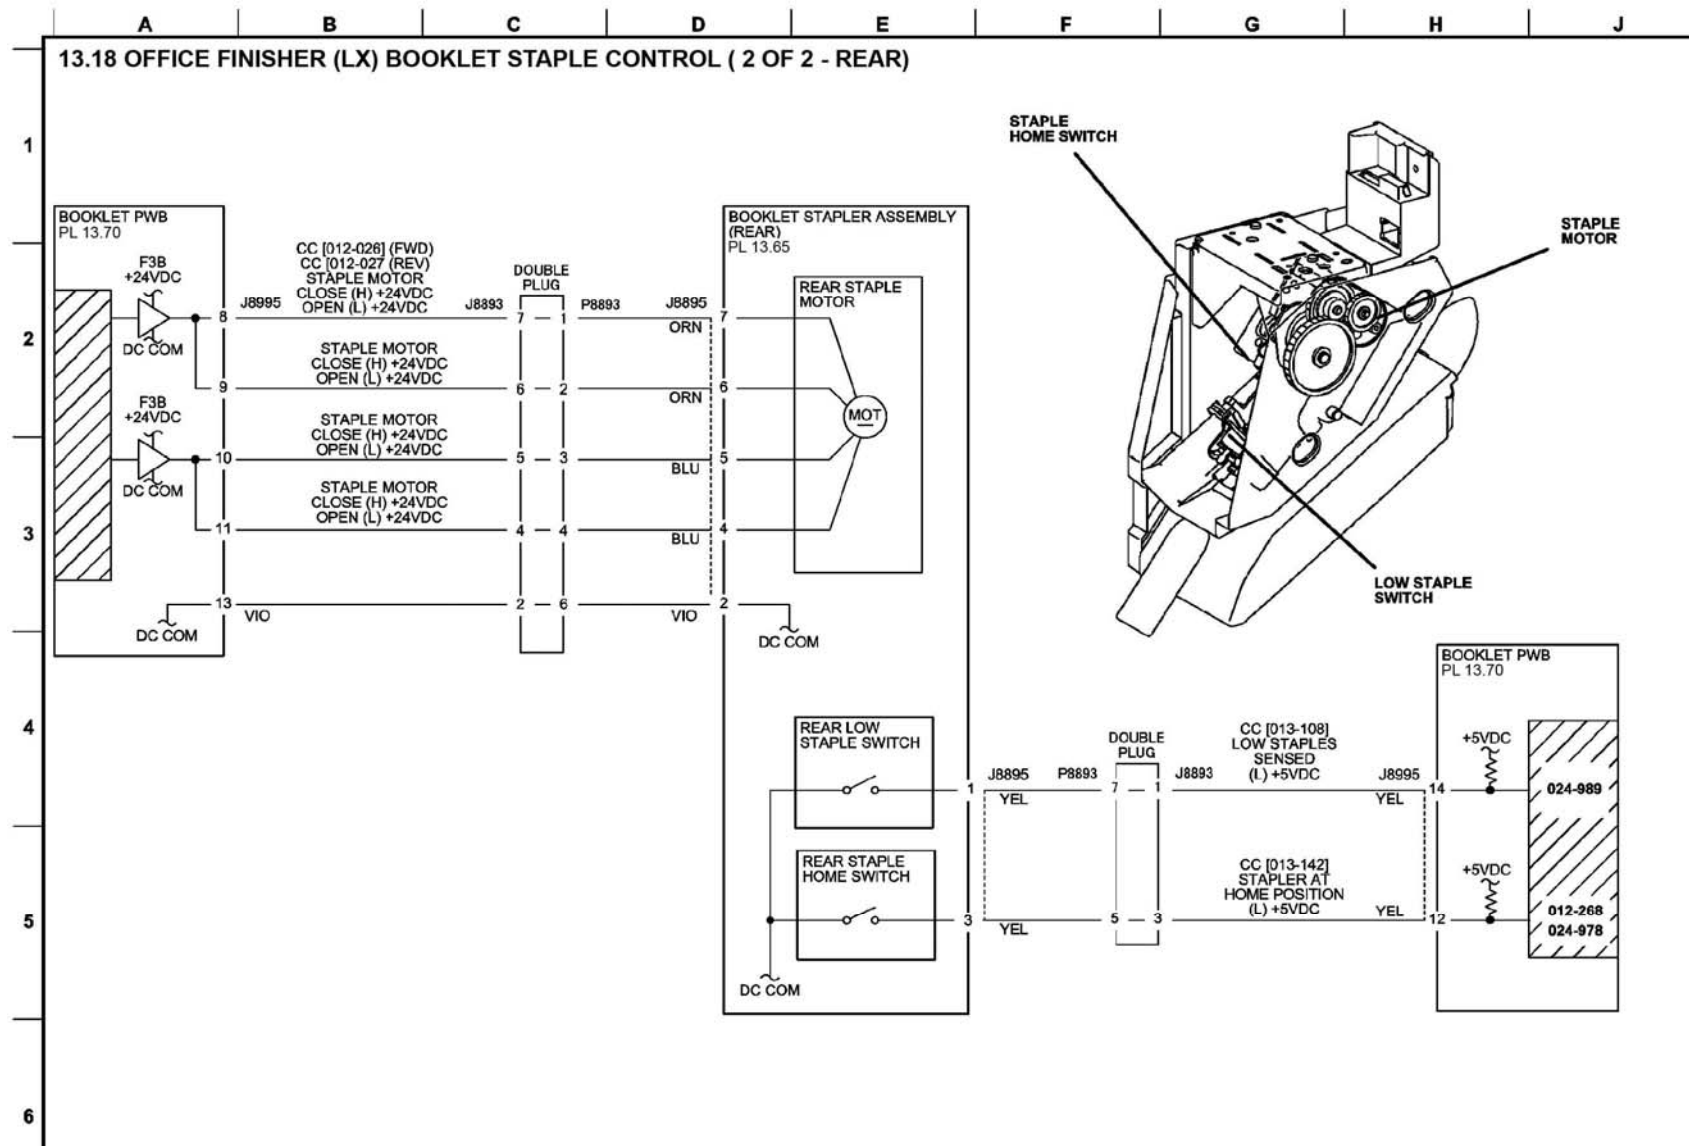
Figure 112 BSD 13.18

BSD 13.18 Office Finisher LX Booklet Staple Control (2 of 2 - Rear)

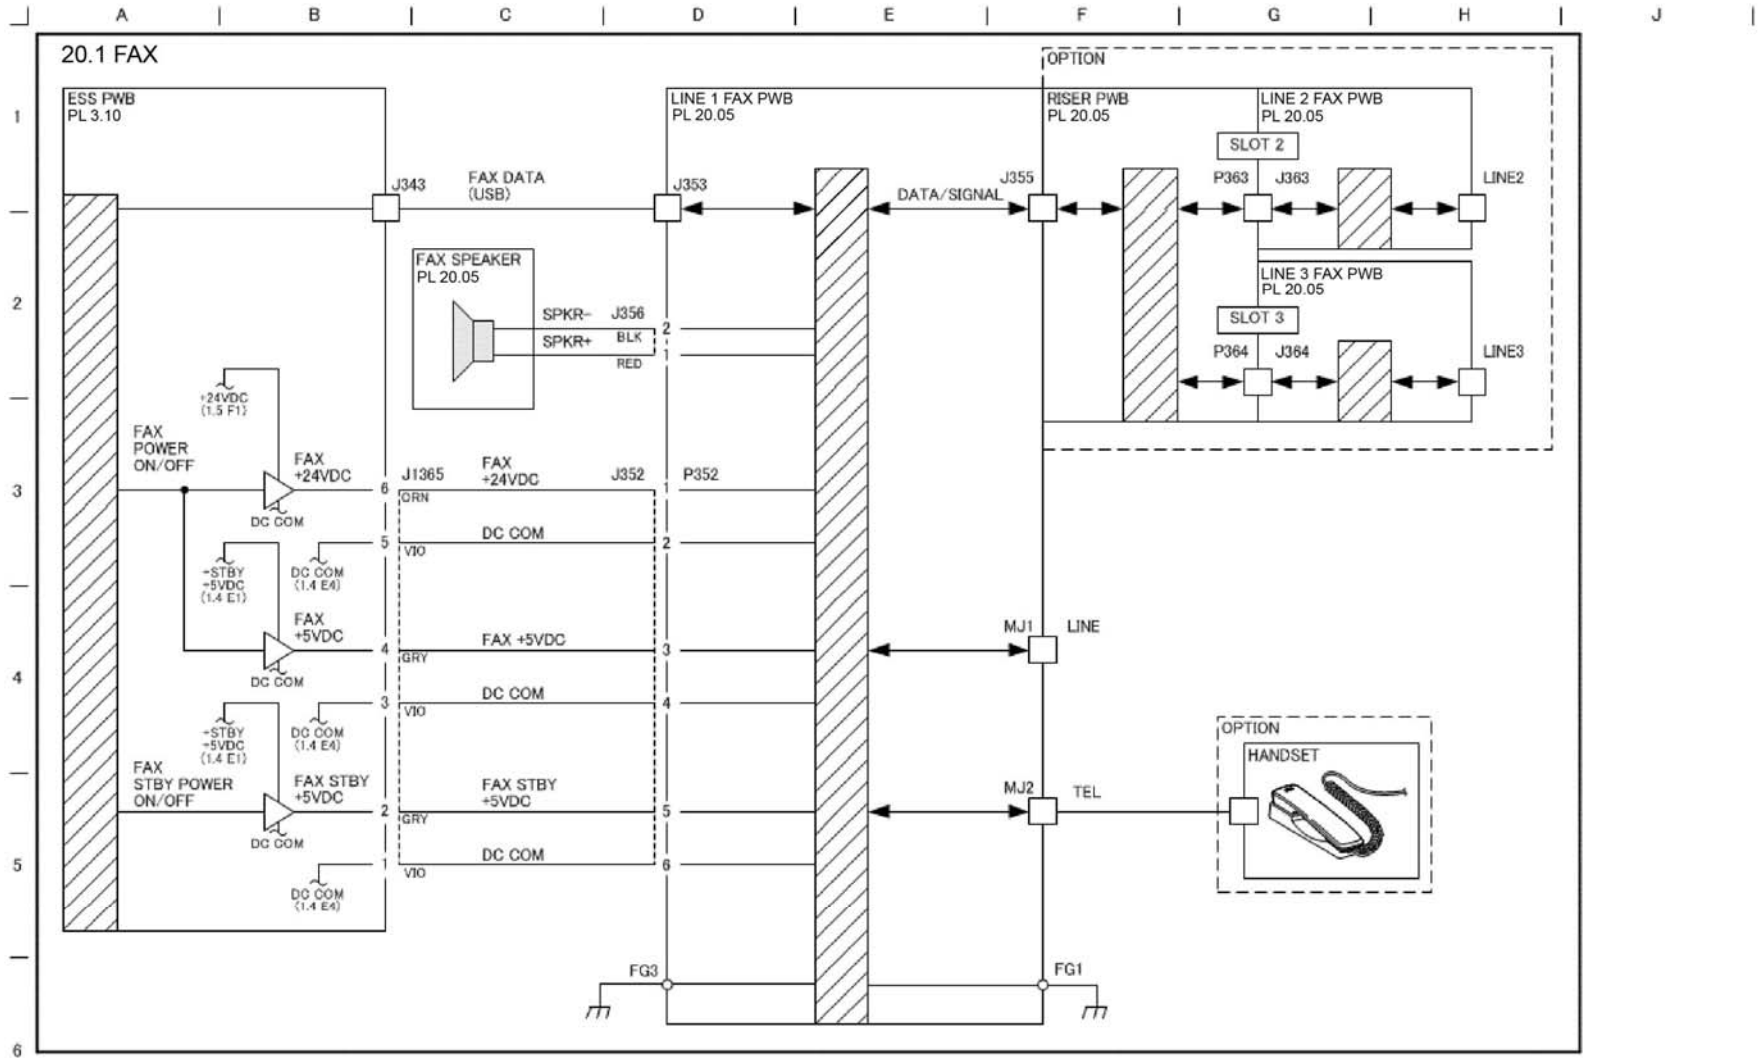
Figure 113 BSD 20.1

BSD 20.1 Fax

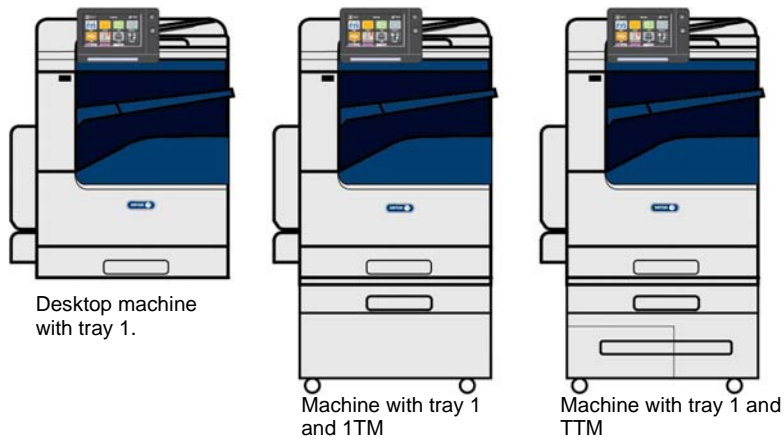
- Duplexing automatic document feeder (DADF); IOT with duplex path.
- Color image input terminal (IIT) for full color document scanning.
- Color scan to print from USB.
- Color scan to email/mailbox.
- Monochrome print engine running at 25, 30, or 35ppm.
- One paper tray.
- Offsetting center catch tray (exit 1 only) and exit 2 tray.
- Multi sheet inserter (MSI/bypass tray).

Figure 1 Xerox® VersaLink® B7025/B7030/B7035

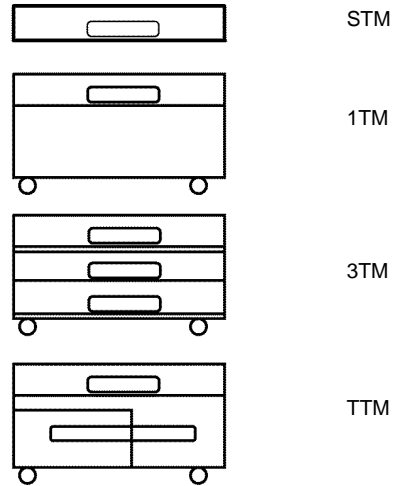
- STM - single tray module used in desktop configuration.
- 1TM - tray 1 tray module with wheeled stand.
- 3TM - three tray module.
- TTM - tandem tray module.
- Envelope tray.
- 2K HCF (requires 1TM/3TM/TTM).
- Integrated office finisher.
- Office finisher LX (requires 1TM/3TM/TTM).
- Booklet creaser (requires office finisher).
- Hole Punch (requires office finisher).
- Work surface.
- HDD (standard for stacked configurations).
- Center tray/dual catch tray (standard for stacked configurations).
- WiFi.
- CAC reader.
- Convenience stapler.
- 1 or 3 line fax.
- Fax over IP (VOIP fax).
- Adobe PS.

Figure 2 Paper supply options

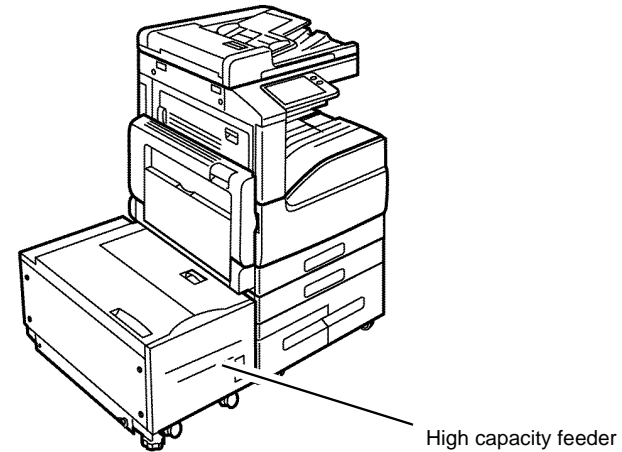
The high capacity feeder (HCF) is a dedicated paper tray with a capacity of approximately 2000 sheets of 60 to 215gsm (16lb bond to 80lb cover) paper. It can handle paper sizes of A4 LEF, 7.25x10.5 inch LEF, or 8.5x11 inch LEF. Refer to [Figure 3](#).

Figure 3 High capacity feeder

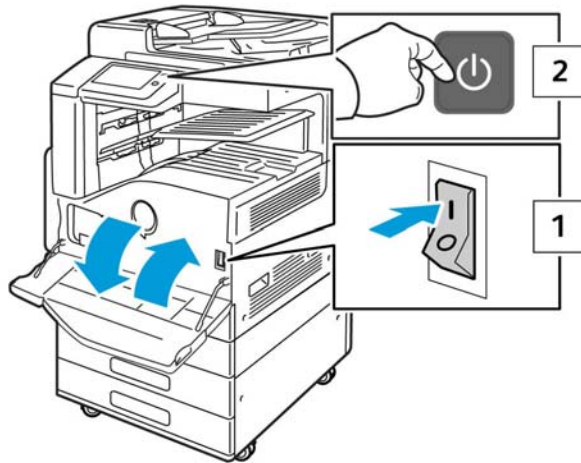
The ESS PWB monitors the UI power button. When the UI power button is pressed the ESS PWB detects the change in status and enables the low voltage power supply to begin producing and distributing both the +5VDC and +24VDC power required for operation.

Figure 1 Main power switch and UI power button

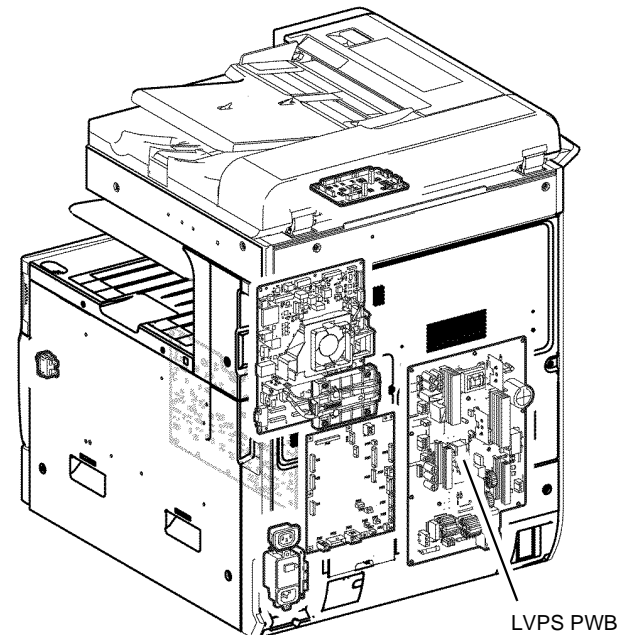
After the power switch is turned on, the +5VDC on/off signal, the +24VDC on/off signal, and the +5VDC C-F On/off signal (fax) cause the low voltage power generation circuits to begin operation.

Figure 2 LVPS PWB

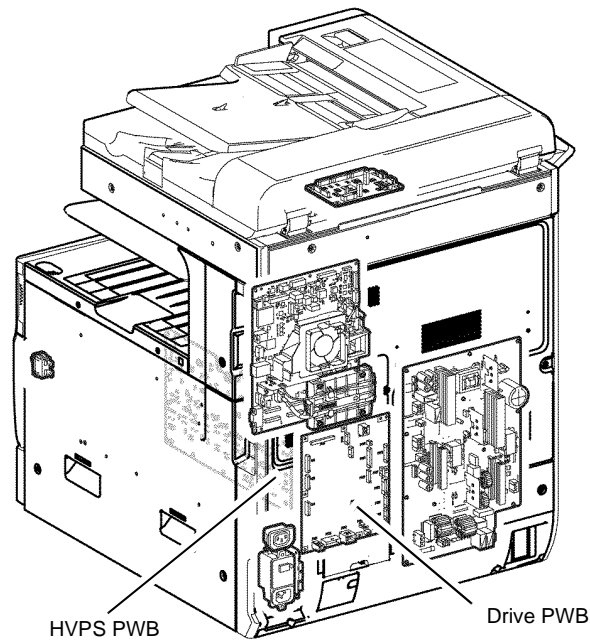
The HVPS is mounted behind the drive PWB, refer to [Figure 3](#).

Figure 3 HVPS PWB

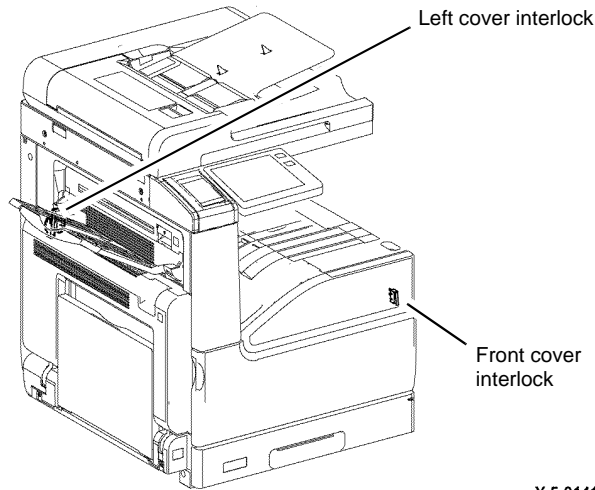
The front cover interlock switch is wired in series with the L/H cover interlock switch. These switches are supplied with +5VDC power from the LVPS. The drive PWB monitors their status.

When the front cover interlock switch opens, fault code 077-300 front cover open sets and the drive PWB de-energizes the interlock relay located on the LVPS. Simultaneously, the fault code and a message to close the front cover display on the UI. With the interlock relay de-energized, the supply of +24VDC power is removed from the drive PWB and the devices it supplies and/or controls (tray module PWB, motors, clutches, solenoids, fans and xerographics). Refer to [Figure 4](#).

Figure 4 Front cover and left cover interlocks

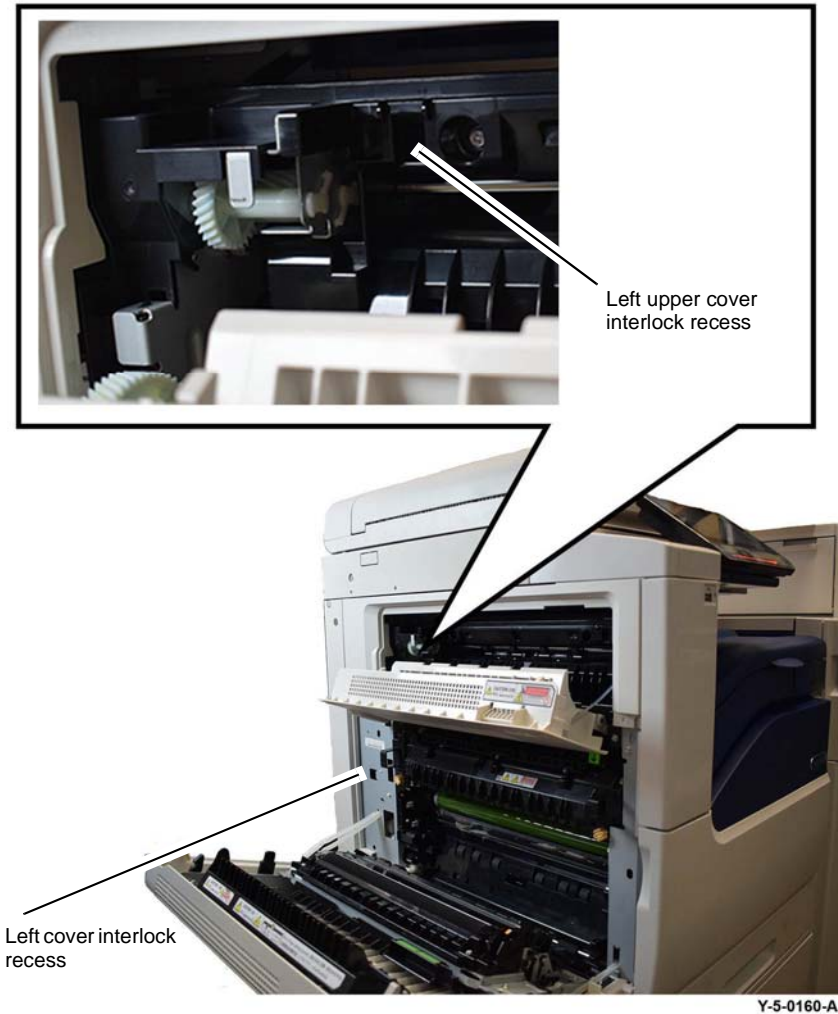
The left upper cover switch, [Figure 5](#), is supplied with +5VDC power from the drive PWB, which also monitors its status.

When the left upper cover switch opens, fault 077-308 left hand high cover open is declared and a message to close the cover displays on the UI. The machine inhibits printing until the user closes the cover, canceling the condition.

Figure 5 Interlocks on left covers

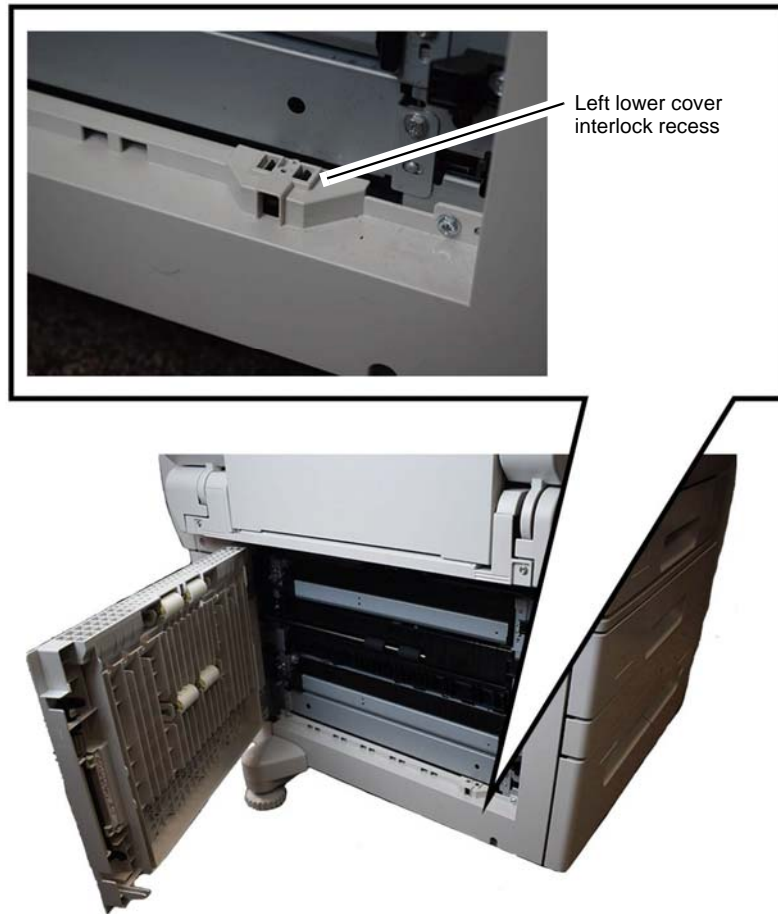
- TTM [PL 70.95 Item 18](#).
- 1TM [PL 80.15 Item 3](#).
- 3TM [PL 80.30 Item 8](#).

Figure 6 Left lower cover interlock

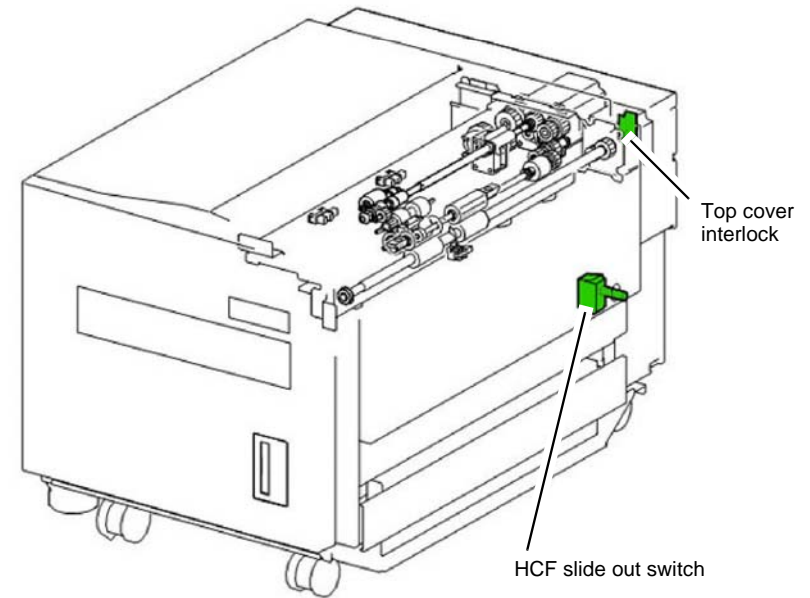
- Top cover interlock, [PL 70.55 Item 26](#).
- HCF slide out switch, [PL 70.60 Item 8](#).

Figure 7 HCF interlocks

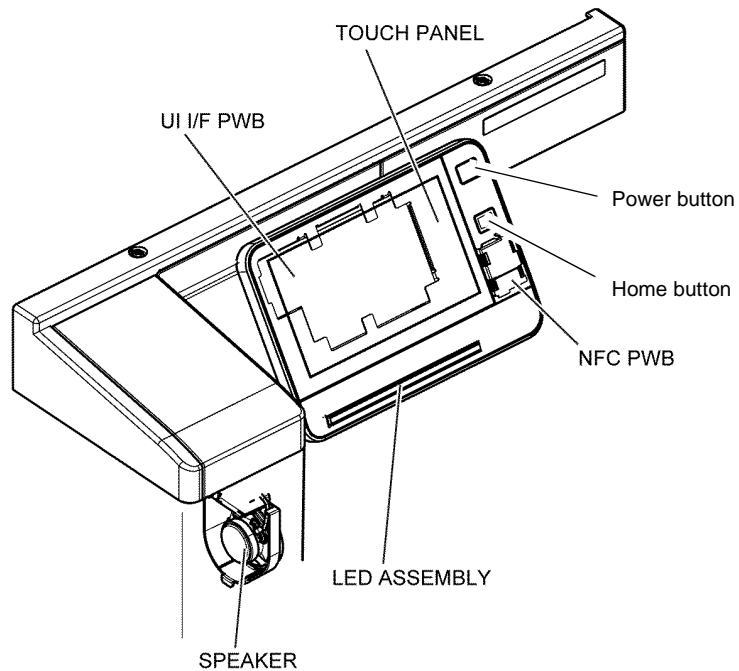
- LCD touch screen.
- Power button.
- Home button.
- LED machine status display.
- Near field communication receiver.

NOTE: The UI assembly, [PL 2.05 Item 7](#) is replaced as a single item. The components within the UI are not accessible.

Figure 1 User interface

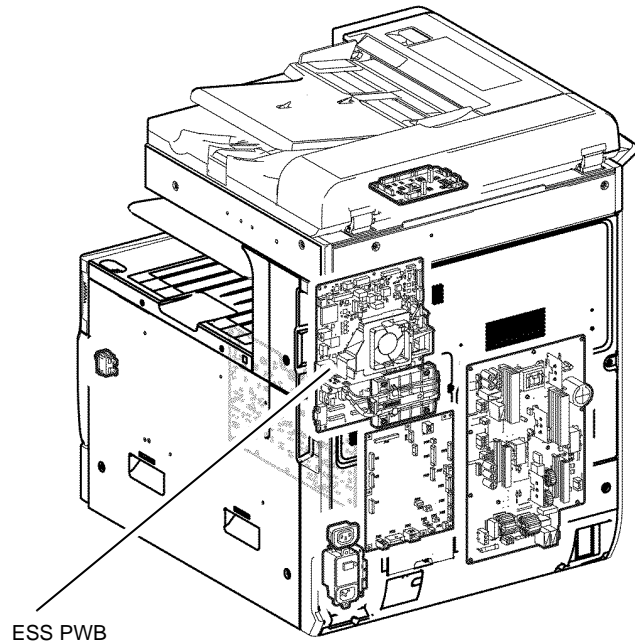
Figure 1 ESS PWB

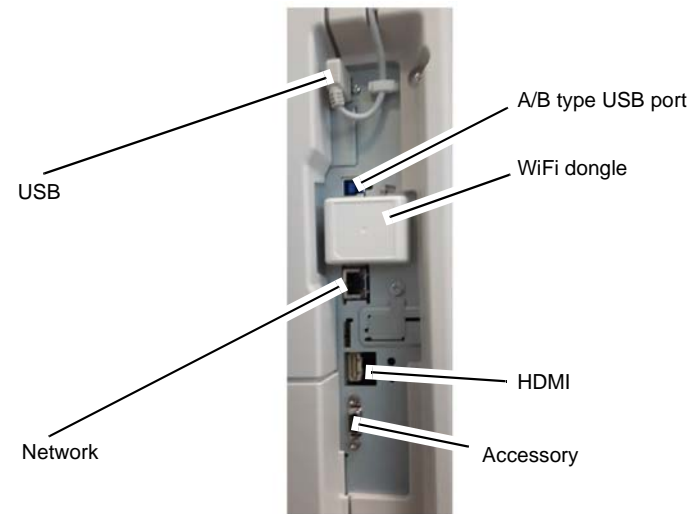
The functions of the connectors along the side of the ESS PWB are shown in [Figure 2](#).

Figure 2 Controller interface

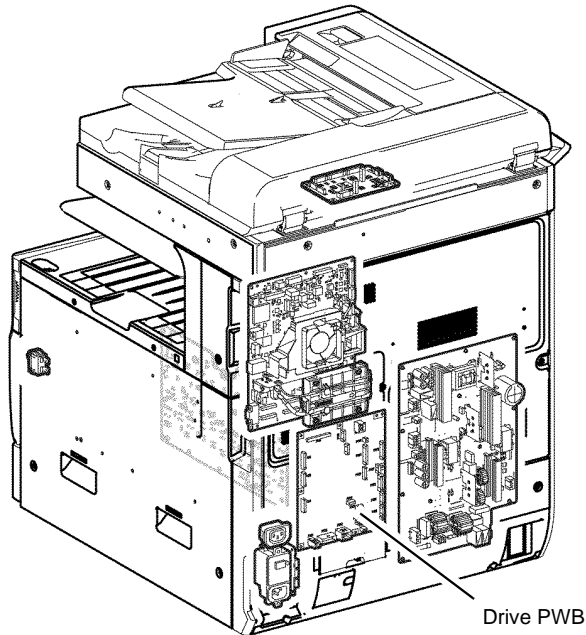
Figure 3 Drive PWB

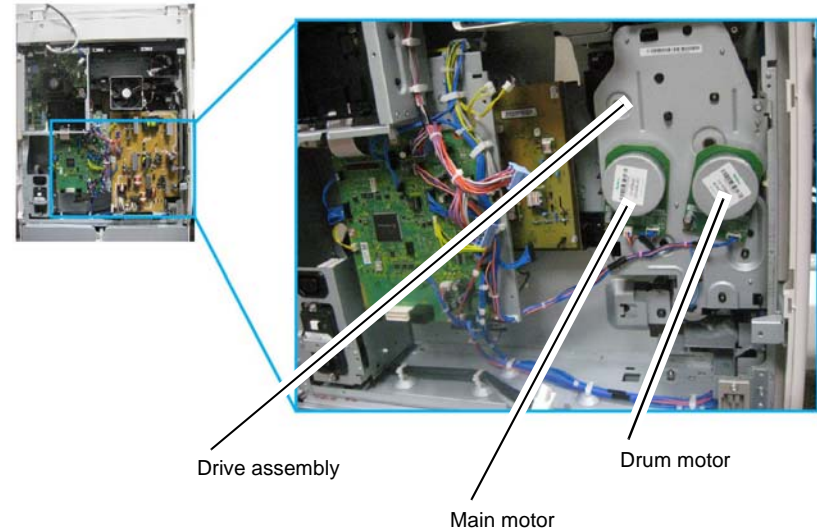
The main drive module [PL 40.05 Item 1](#), is located to the rear of the machine behind the LVPS, [PL 1.10 Item 8](#). Refer to [Figure 1](#).

Figure 1 Main drive assembly

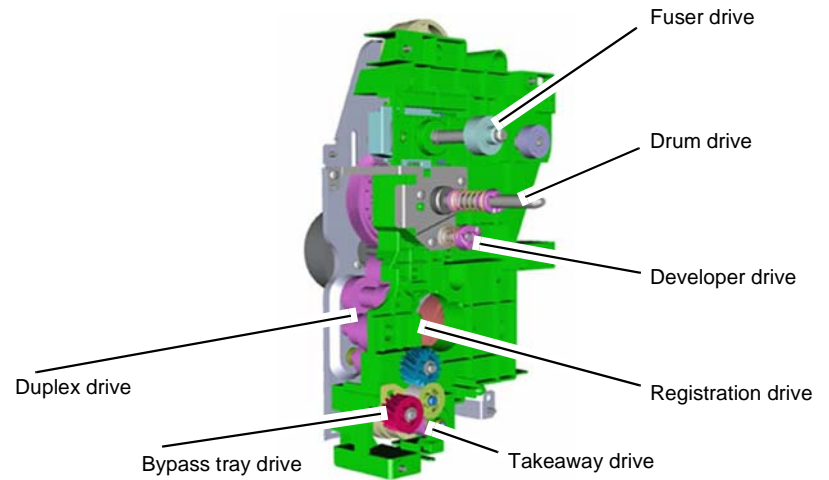
The main drive couplings are shown in [Figure 2](#).

Figure 2 Main drives couplings side
