708P91370
April 2017

Xerox® VersaLink® B7025/B7030/B7035 Multifunction Printer Service Manual

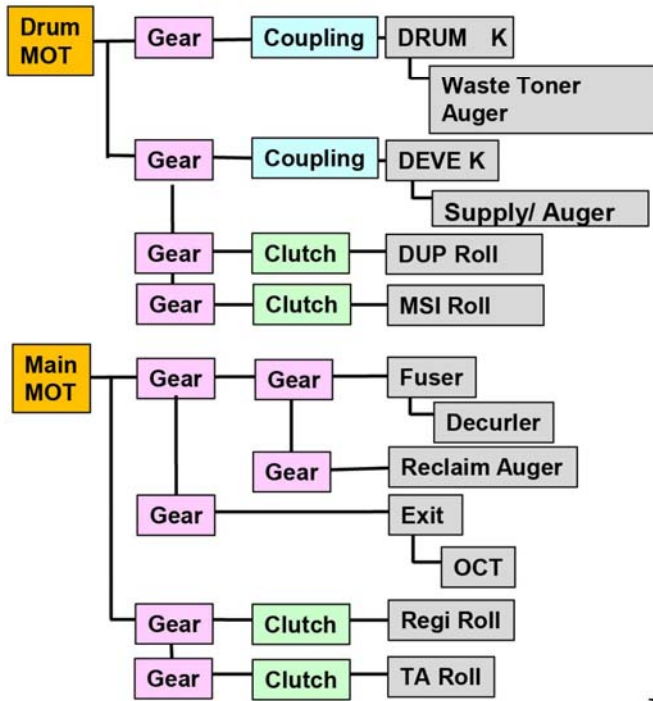
The drive train for the main motors is shown in the schematic in [Figure 3](#).

Figure 3 Main drives

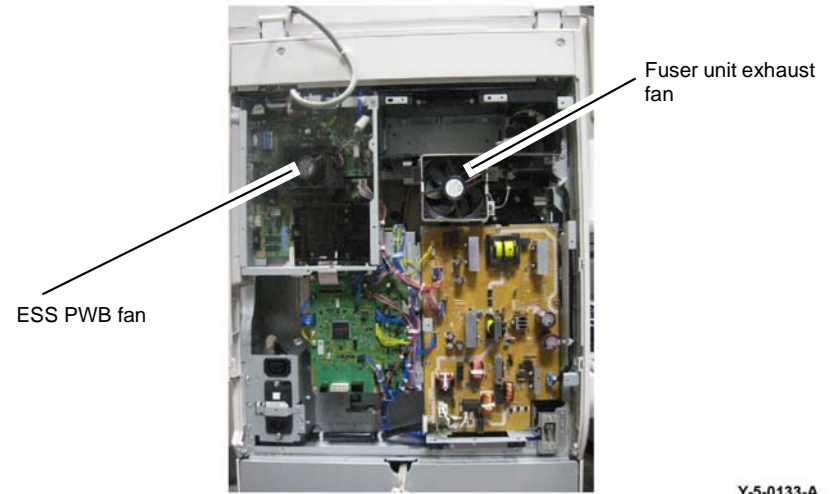
Figure 4 Fuser unit exhaust fan

- Fuser unit exhaust fan, [PL 40.15 Item 4](#) inside the upper rear cover. Refer to [Figure 4](#).
- Marking fan, [PL 40.15 Item 8](#) at the front of the machine inside the inner cover. The fan position is not visible on the inner cover.

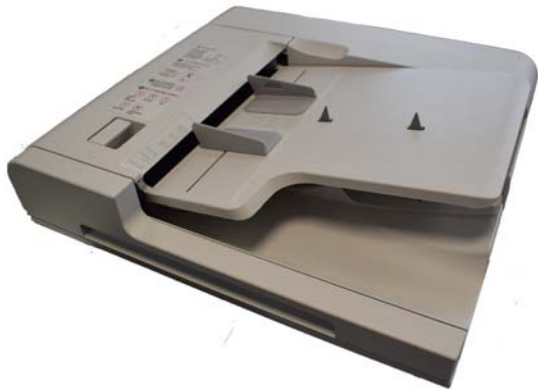
Figure 1 DADF

The DADF can invert a document to scan images on both sides, and it employs a constant velocity transport (CVT) system. With the CVT system, the lamp carriage of the IIT is fixed at a specified position (the scan position) where images are scanned as documents feed across the platen at a constant speed. Refer to [Figure 1](#).

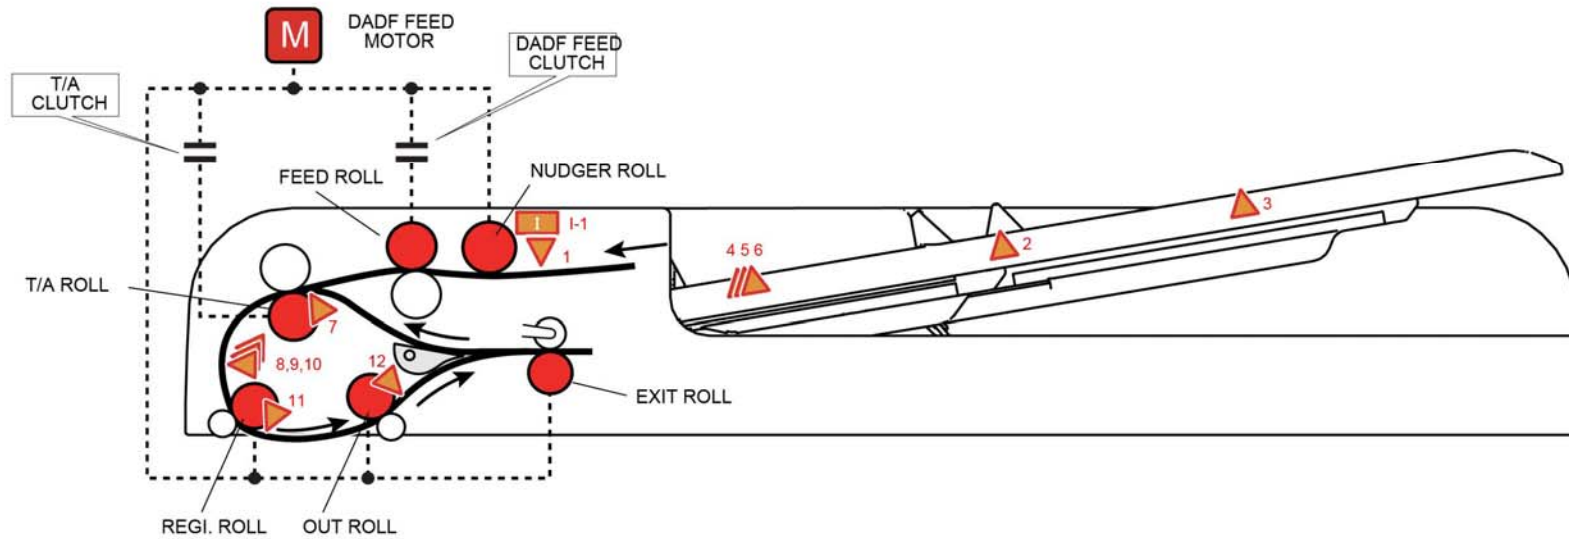
Figure 2 shows the relative locations of the DADF components used to sense, size, and feed documents.

No.	Sensor Name	CH
1	DADF DOCUMENT SET SENSOR	5.1
2	DOCUMENT TRAY SIZE SENSOR 1	5.2
3	DOCUMENT TRAY SIZE SENSOR 2	5.2
4	DADF TRAY SET GUIDE SENSOR 1	5.3
5	DADF TRAY SET GUIDE SENSOR 2	5.3
6	DADF TRAY SET GUIDE SENSOR 3	5.3
7	DADF PRE REGI. SENSOR	5.4
8	DADF APS SENSOR 1	5.5
9	DADF APS SENSOR 2	5.5
10	DADF APS SENSOR 3	5.5
11	DADF REGI. SENSOR	5.6
12	DADF INVERT SENSOR	5.8

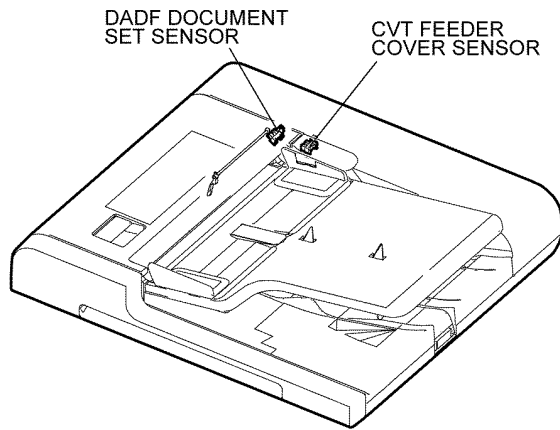
Figure 3 Document set sensor

When a document is placed in the document tray, it activates the document sensor, [PL 5.30 Item 7](#).

The CVT feeder cover sensor detects that the upper feeder assembly, [PL 5.10 Item 10](#), is closed. Refer to [Figure 3](#).

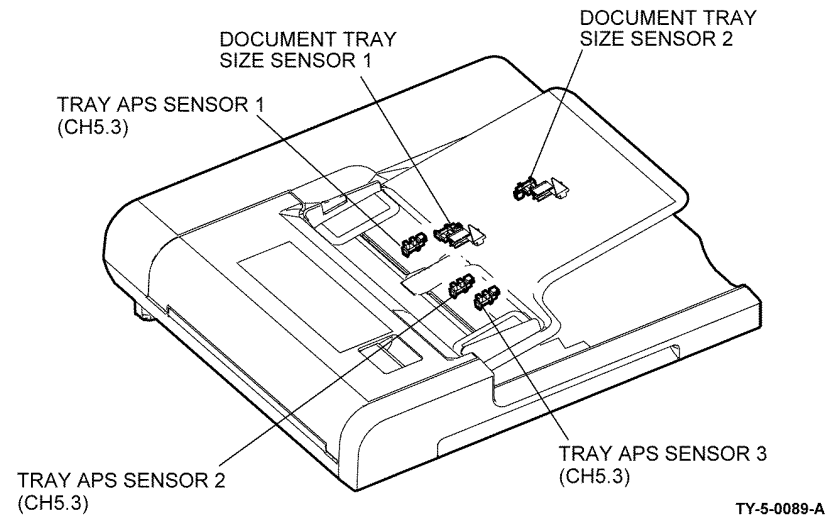
Figure 4 Tray APS sensors and size sensors

When a document stack of different sizes is set, the document size is detected according to the combination of the maximum width and length of the documents.

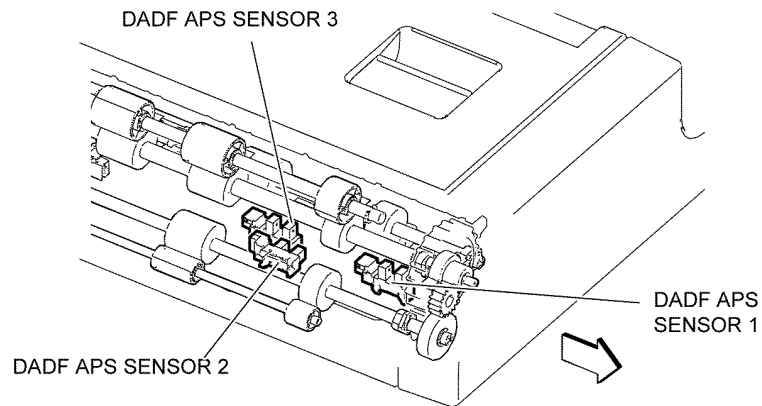
Figure 5 DADF APS sensors

DADF APS sensors 1, 2 and 3 detect the document width in the cross process direction, [PL 5.50 Item 8](#). These sensors monitor the document width (cross process direction) as the documents passes along the document path. They allow multiple sized documents to be processed in a single job. Refer to [Figure 5](#)

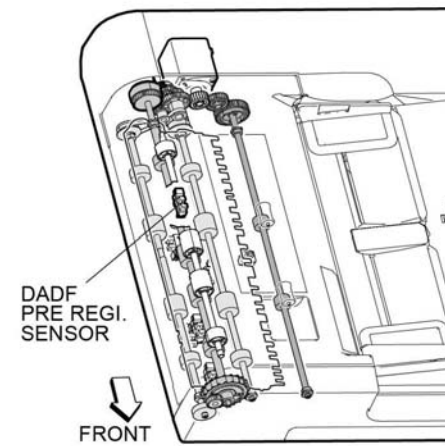
Figure 6 Pre-registration sensor

The DADF pre-registration sensor, [PL 5.70 Item 3](#), is installed immediately before the take-away roll. It detects that the preceding sheet has left the takeaway roll. Refer to [Figure 6](#).

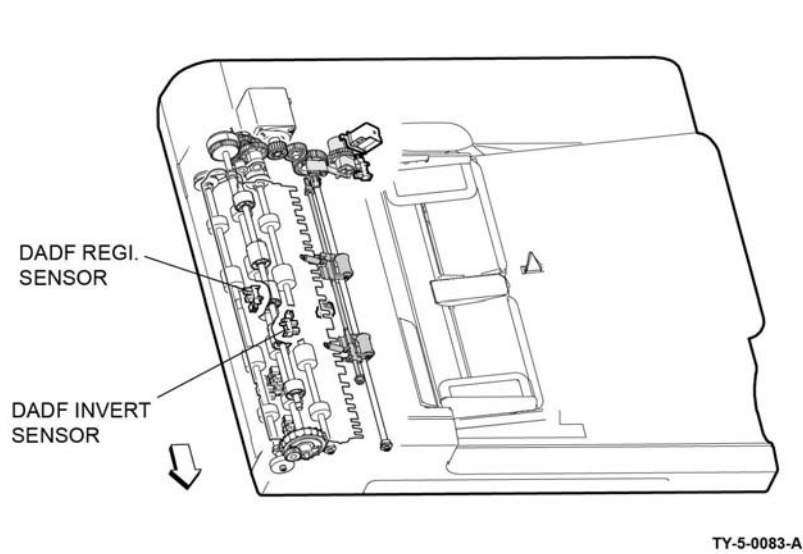
Figure 7 Registration sensor and invert sensor

The registration sensor and the pre-registration sensor provide jam detection as the document feeds through the document path.

The DADF invert sensor is installed immediately after the out roll. It detects the ejection of a sheet and provides timing data for two sided jobs. Refer to [Figure 7](#).

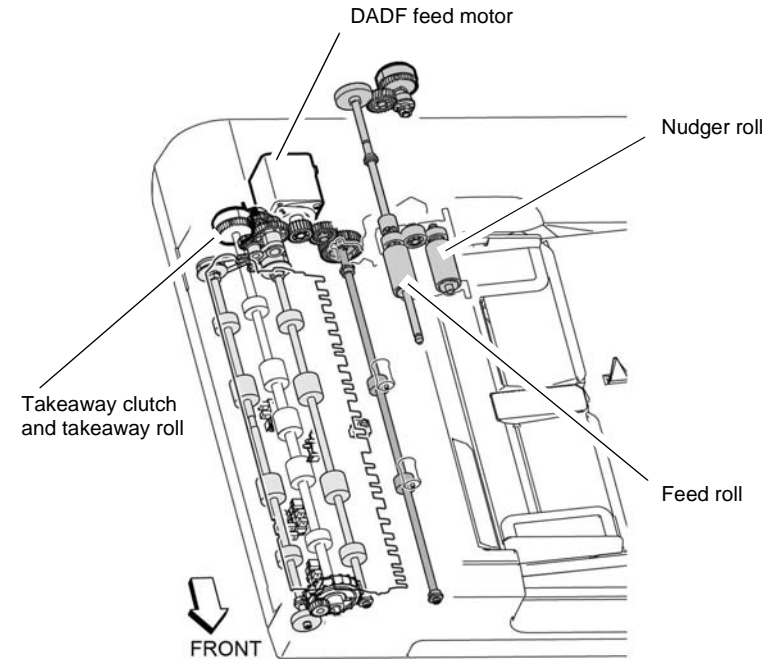
Figure 8 Document feed mechanism

The DADF feed motor is a stepping motor that rotates the nudger roll and feed roll in the reverse (CCW) direction. It also rotates the takeaway roll in the normal (CW) direction. The takeaway roll stops when this motor rotates in the reverse direction.

The feed roll and the takeaway roll are driven through clutches that are controlled by the DADF PWB, [PL 5.10 Item 11](#). Refer to [Figure 8](#).

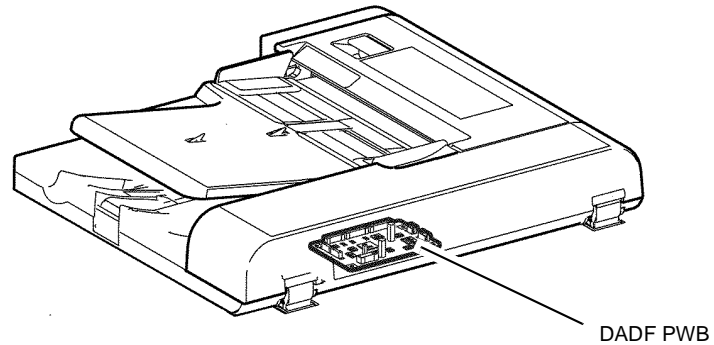
Figure 9 DADF PWB

The DADF PWB, [Figure 9](#), controls the following:

- DADF feed motor, [PL 5.30 Item 3](#).
- DADF feed clutch, [PL 5.35 Item 2](#).
- Takeaway clutch, [PL 5.35 Item 2](#).
- Exit nip release solenoid, [PL 5.35 Item 8](#).

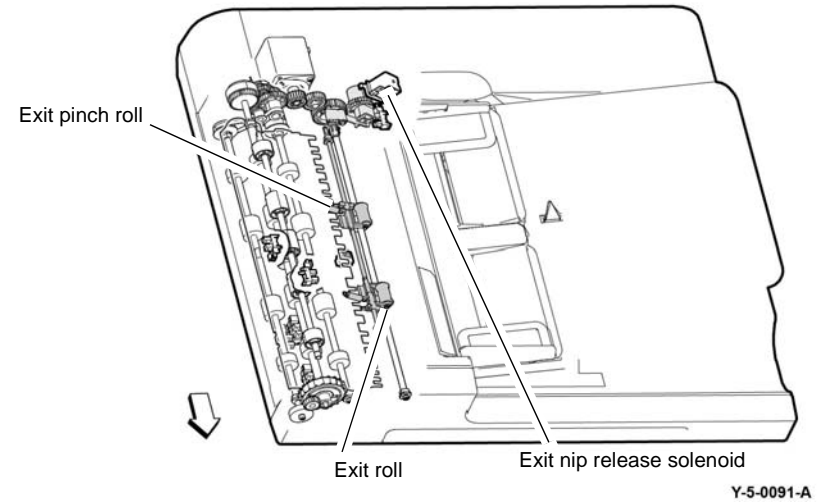
Figure 10 Exit roll and nip release solenoid

The exit nip release solenoid releases the nip on the exit roll, [PL 5.50 Item 3](#), and exit pinch roll, [PL 5.65 Item 13](#). The exit nip solenoid is normally off and the exit roll and pinch roll are nipped. Springs, [PL 5.65 Item 18](#), hold the pinch rolls against the exit roll when the 2 rolls are nipped. When the solenoid is activated the exit roll and exit pinch roll are released. The exit roll is driven directly by the feed motor. Refer to [Figure 10](#).

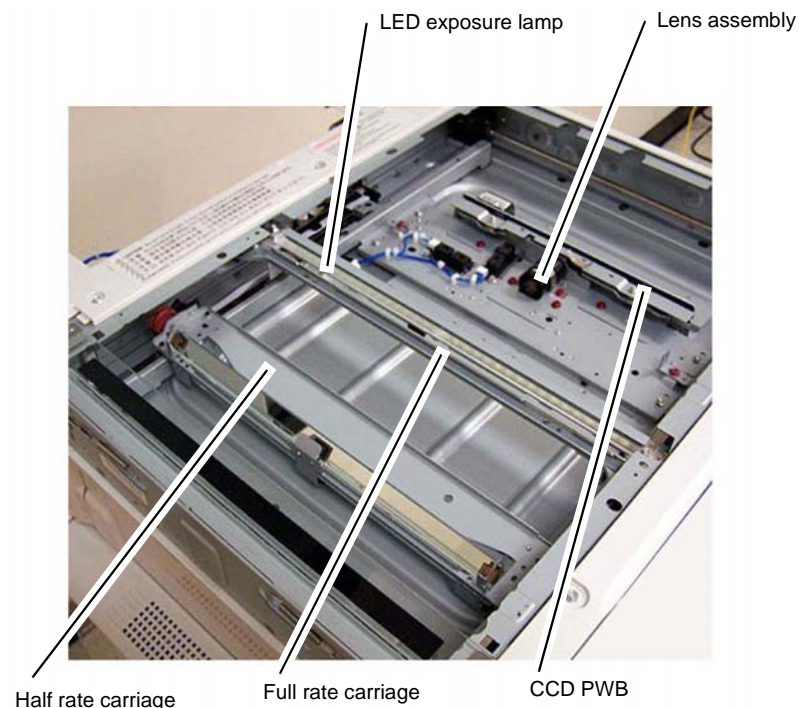
Figure 1 IIT

The image of the document is reflected by the mirrors on the full and half rate carriages to the lens assembly. The image is focused by the lens onto the charge-coupled device (CCD). The CCD array converts the optical information to electrical analog levels that represent the red, green, and blue components of the original image. The CCD array uses a series of red, green and blue filters to separate the reflected image data into its R, G, and B components. Refer to [Figure 1](#).

NOTE: [Figure 1](#) shows the IIT after removal of the lens cover assembly, [PL 60.10 Item 12](#).

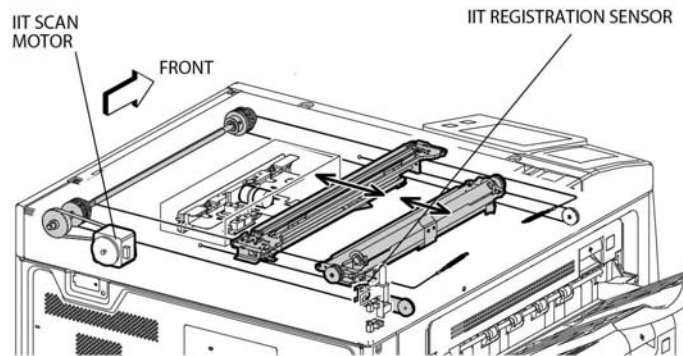
Figure 2 IIT scan motor and registration sensor

The IIT scan motor, [PL 60.30 Item 5](#) drives the full and half rate carriages via cables and pulleys. The carriage motor is a stepper motor that precisely controls the movement of the scan carriages beneath the document glass.

The IIT registration sensor, [PL 60.30 Item 7](#) is used to establish the home position of the carriages so that the control logic knows their locations. Refer to [Figure 2](#).

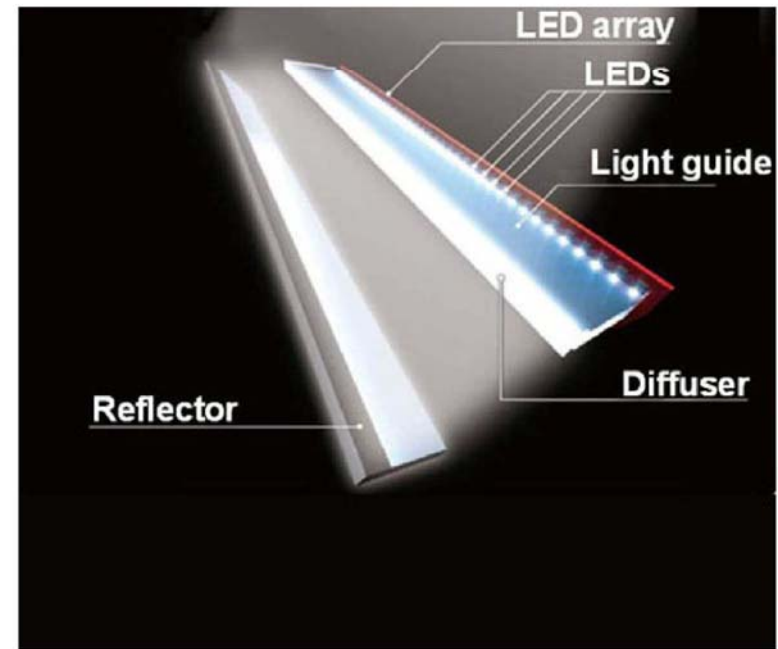
Figure 3 LED array

The LED exposure lamp consists of a white LED array, a light guide, a diffuser, and a reflector. Refer to [Figure 3](#).

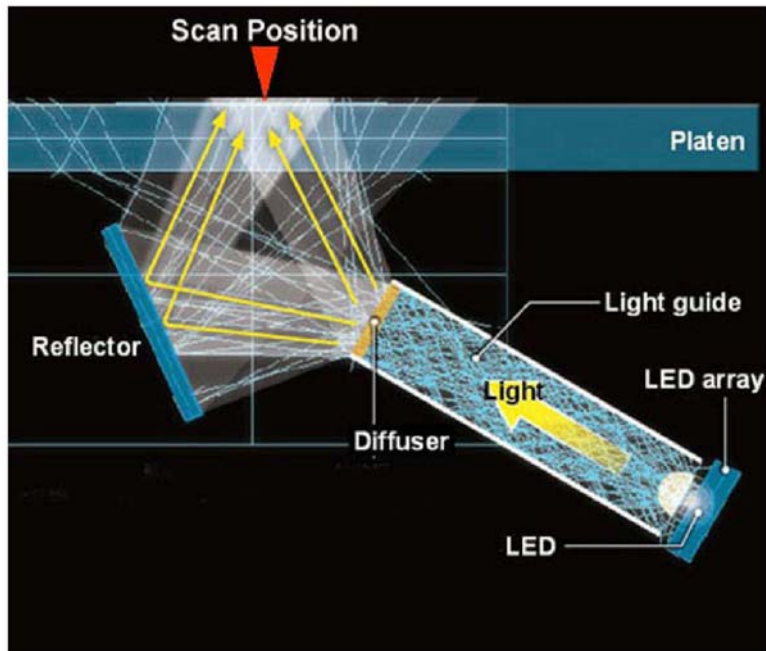
Figure 4 Light diffusion

The light guide and diffuser convert the light from the LED array into a uniform pattern that closely parallels the output from a fluorescent lamp. Refer to [Figure 4](#).

The benefits of this design include uniform and stable light output at lower energy cost, reduced heat output, and faster start up.

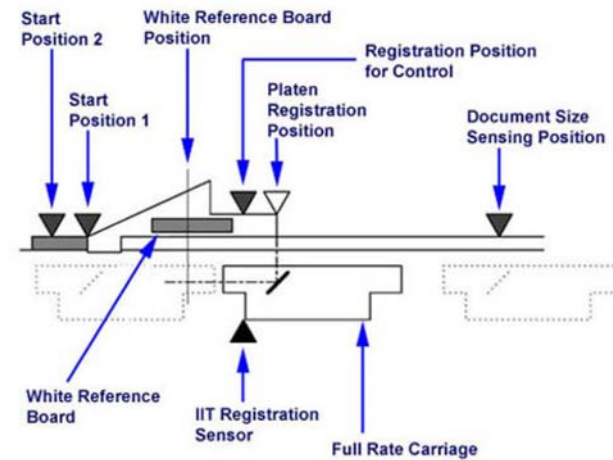
Figure 5 Scanning overview

When a document is scanned from the document glass, the scan cables that drive the full rate and half rate carriages maintain a fixed length optical path between the document and CCD. This is important for accurate size reproduction and focus.

The scan speed varies according to the reduction or enlargement ratio that has been selected. A slow scan produces an enlarged image and a fast scan produces a small image. Electronic processing is used to change the image size in the front- to-back (fast scan) direction when reduction or enlargement is selected. Refer to [Figure 5](#).

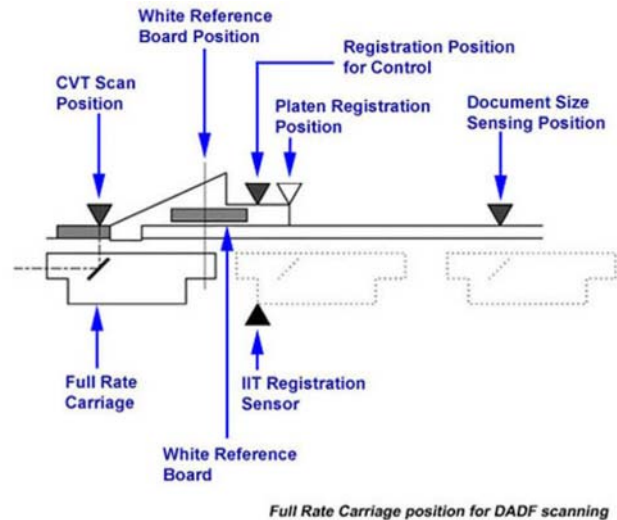
Figure 6 DADF scanning

The stationary half rate and full rate mirrors are used in the usual way to reflect the image through the lens to the CCD.

In all copy modes, the document is only scanned once regardless of the number of copies required. Refer to Figure 6.

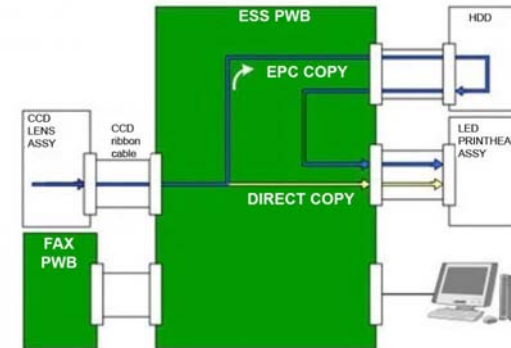
Figure 7 Image flow

The image data from the CCD image sensor are sent to the ESS PWB via the CCD ribbon cable. Shading compensation and white and black correction are then applied to the image data. Refer to Figure 7.

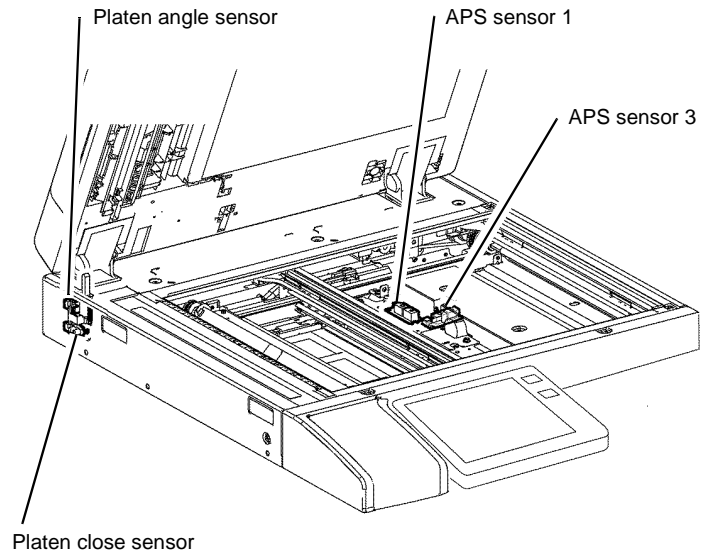
Figure 8 DADF sensors

To determine a document's width, the exposure lamp is switched on momentarily, the document is illuminated, and the CCD image sensor detects the width (fast scan direction) to the nearest millimeter. A document's length (slow scan direction) is detected by the APS sensors 1 and 3. Refer to [Figure 8](#).

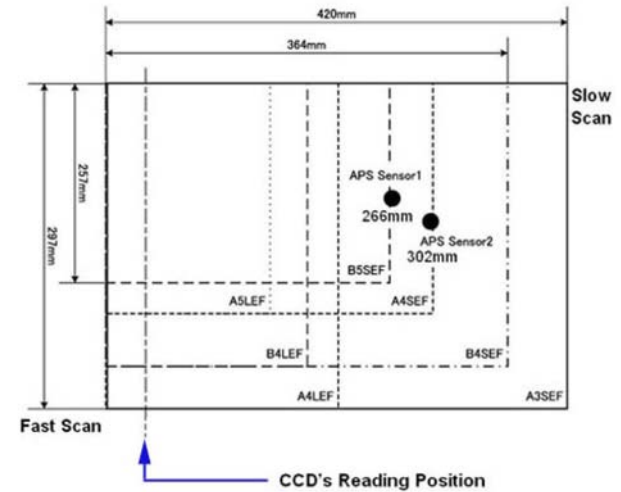
Figure 9 Document size sensing

The IIT has two APS sensors which enable it to distinguish between 8.5x11 inch SEF, 8.5x13 inch SEF, and 8.5x14 inch SEF. Refer to [Figure 9](#).

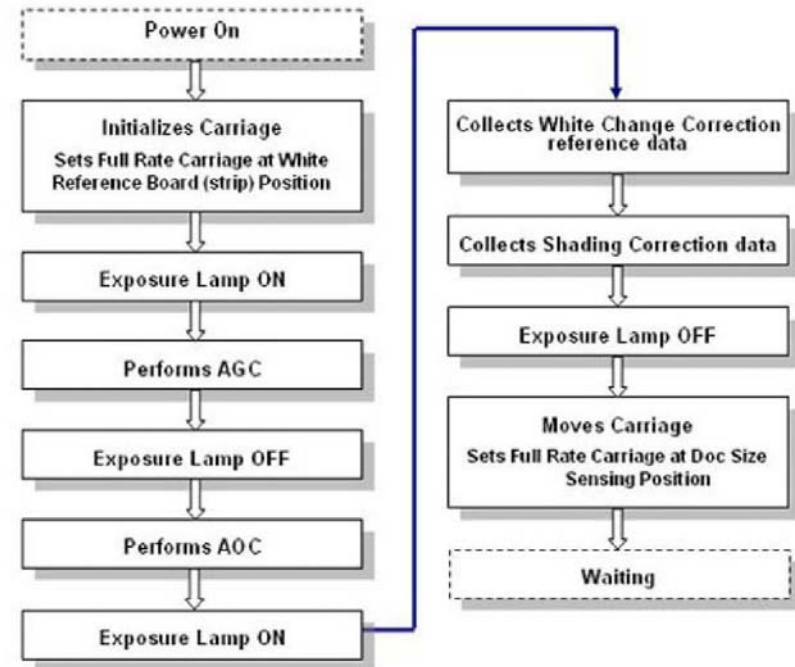
Figure 10 Scanner initialization

The carriage position initializes after the machine is powered on or has recovered from power save mode. Refer to [Figure 10](#).

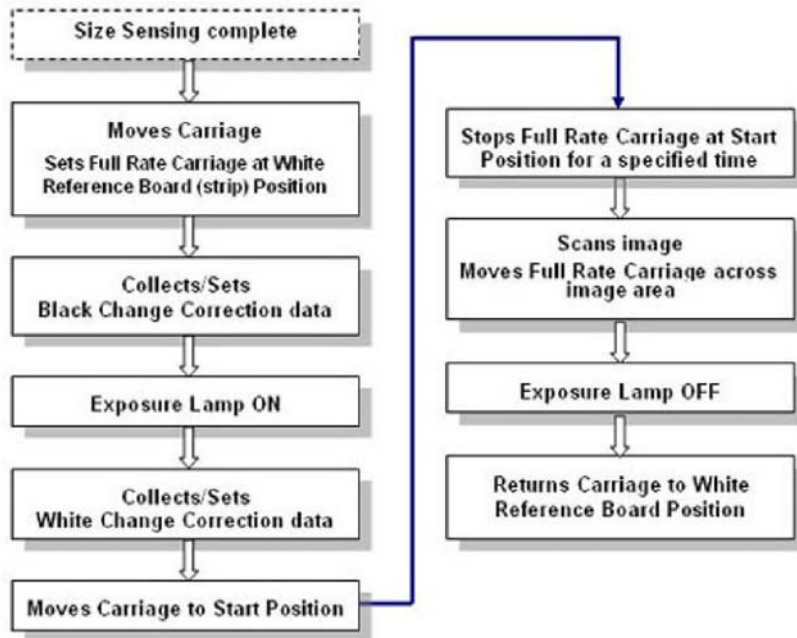
Figure 11 Platen scanning operation

The full rate carriage now moves to the start position, where it waits a specified time. When the wait time elapses, the full rate carriage moves across the image area.

The exposure lamp turns off at the end of the scan, and the full rate carriage returns to the white reference strip position. Refer to [Figure 11](#).

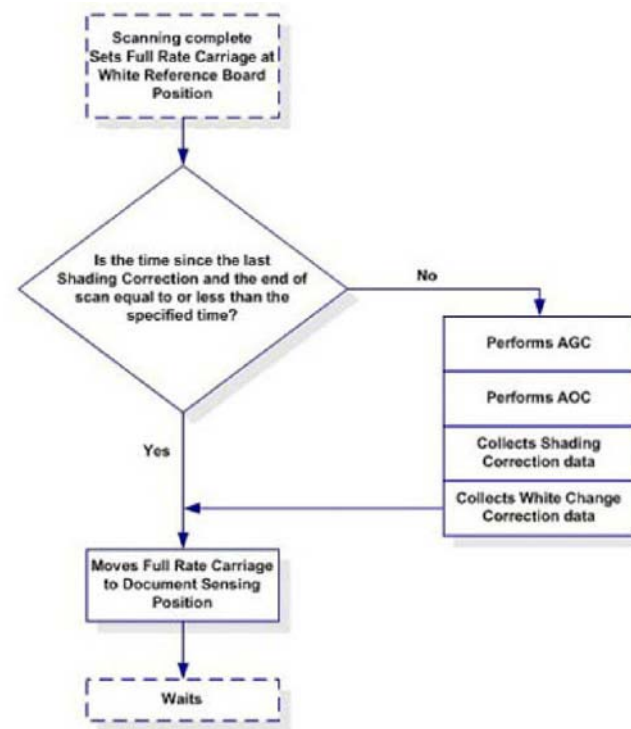
Figure 12 End of platen scanning

If the elapsed time is greater than a specified value, the IIT performs auto gain control and auto offset control, and collects shading correction data and white change correction data.

It then moves the full rate carriage to the document sensing position, where it waits for the next customer job. Refer to [Figure 12](#).

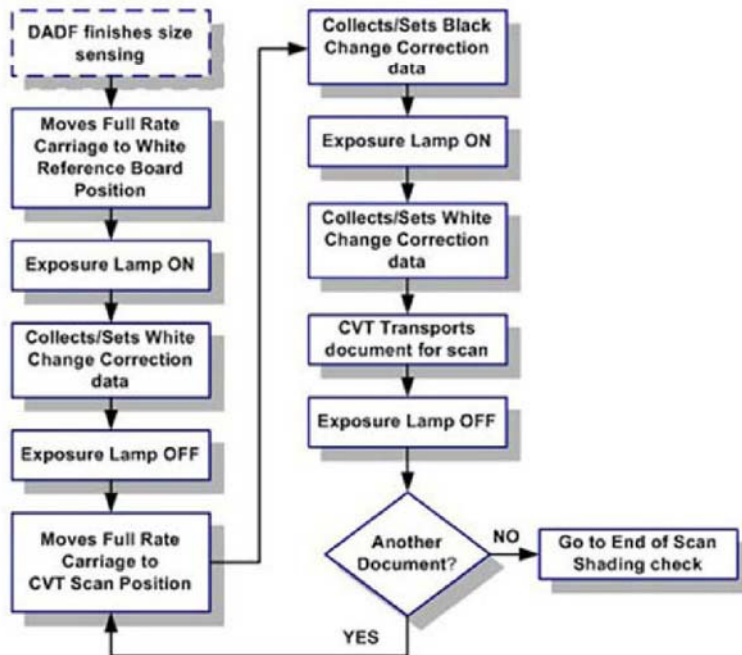
Figure 13 DADF scanning operations

Next the exposure lamp turns off and the full rate carriage moves to the CVT scan position. First it collects and applies black change correction data, then it turns on the exposure lamp and collects white change correction data, setting the white and black levels.

The IIT scans the document as it is transported by the CVT. If there are multiple documents, the full rate carriage stays at the CVT scan position. Refer to [Figure 13](#).

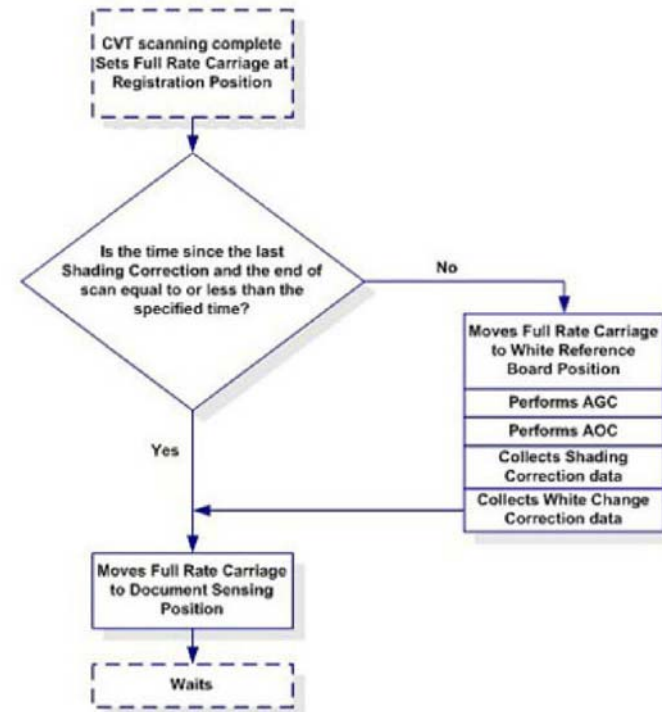
Figure 14 End of DADF scan

If the elapsed time is greater than a specified value, the IIT moves the full rate carriage to the white reference strip position and performs AGC and AOC, and collects shading correction data and white change correction data.

It then moves the full rate carriage to the document sensing position, where it waits for the next customer job. Refer to [Figure 14](#).

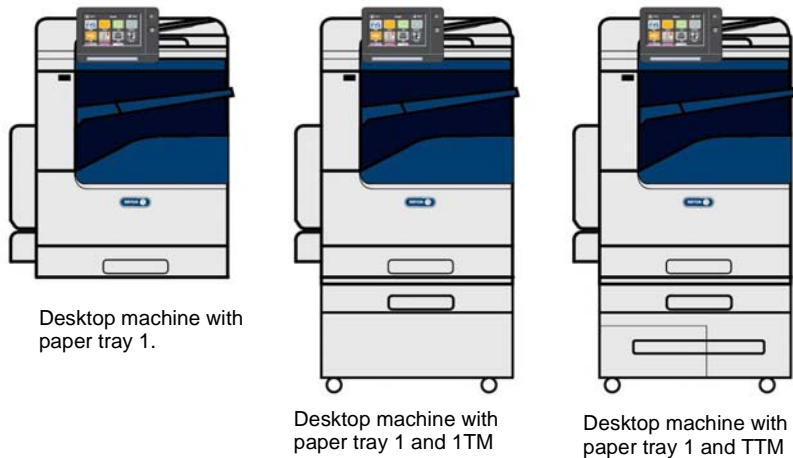
Figure 1 Basic configuration

There are three basic Xerox® VersaLink® B7025/B7030/B7035 machine paper supply configurations, [Figure 1](#):

- Desktop machine with paper tray 1, [PL 70.05](#).
- Stacked machine with paper tray 1 and 1 tray module (1TM), [PL 70.15](#).
- Stacked machine with paper tray 1 and tandem tray module (TTM), [PL 70.65](#).

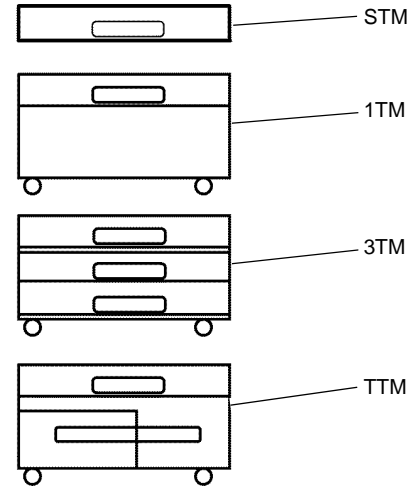
Figure 2 Desktop machine options

There are four Xerox® VersaLink® B7025/B7030/B7035 optional paper supply configurations for the desktop machine, [Figure 2](#):

- Desktop machine with single tray module (STM), [PL 70.25](#).
- Desktop machine with 1TM, [PL 70.15](#).
- Desktop machine with 3 tray module (3TM), [PL 70.20](#).
- Desktop machine with TTM, [PL 70.65](#).

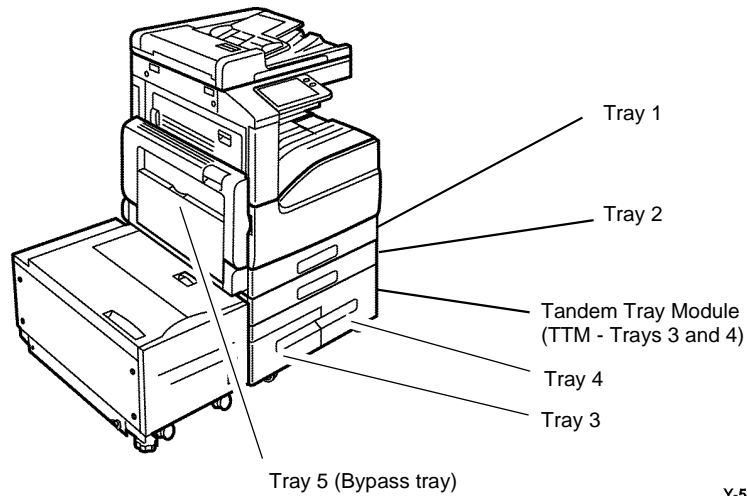
Figure 3 Media supply trays

All the Xerox® VersaLink® B7025/B7030/B7035 machine configurations feature a bypass tray (Tray 5), [PL 70.30](#). The machine can also be configured with an optional high capacity feeder (HCF), [PL 70.45](#) and [Figure 3](#).

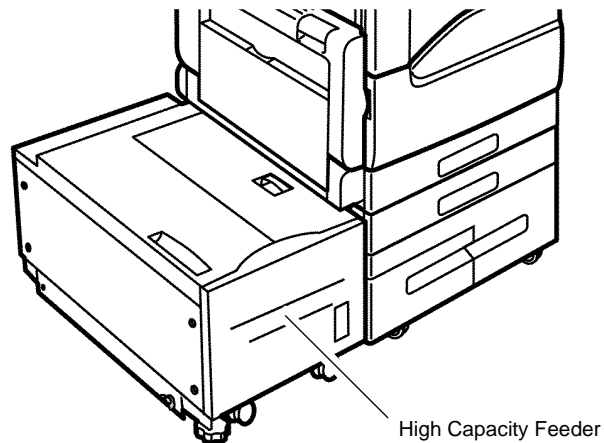
Figure 4 High capacity feeder

The HCF can only be installed on machines configured with either a 1TM, 3TM or TTM, [Figure 4](#).

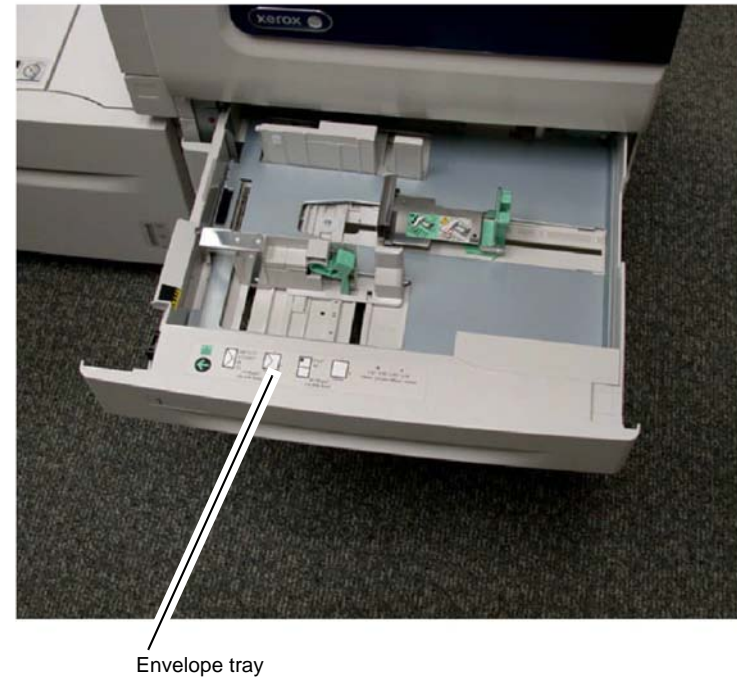
Figure 5 Envelope tray

An optional envelope tray is available, [PL 70.100 Item 1](#). The envelope tray is installed by the customer in the tray 1 position. Refer to [Figure 5](#).

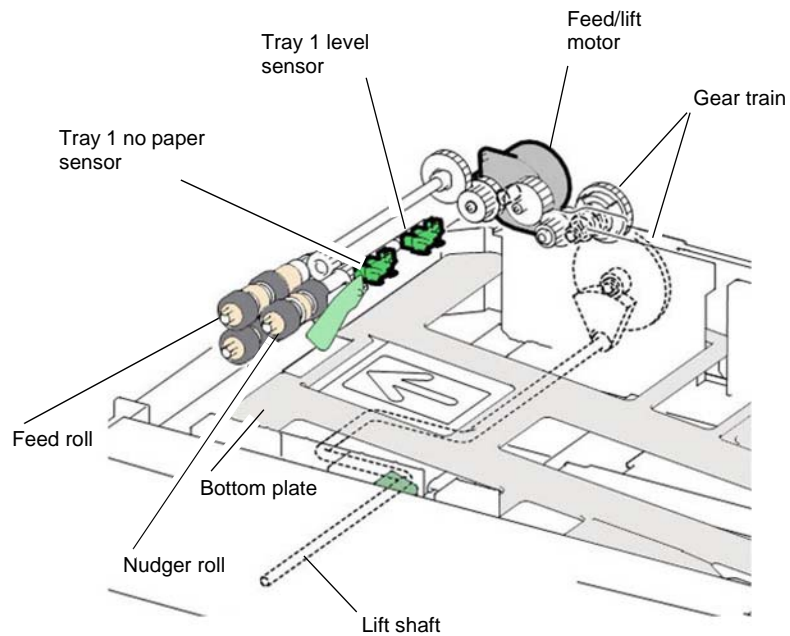
Figure 6 Tray control components

When either of the paper trays 1, 2, 3 or 4 are fully inserted into a powered on machine the state of their tray level sensor is checked by a component control PWB. The STM, 1TM, 3TM and TTM all have an integral control PWB. However, the components of tray 1 are controlled by the drive PWB, **PL 1.10 Item 3**. If the signal tray level sensor off is detected by the control logic, the feed/lift motor is activated to run in the counter clockwise direction (CCW). Thereby, elevating (via a gear train and lift shaft) the bottom plate and paper stack of that tray up to the paper feed position. In the feed position the elevated paper stack actuates the tray level sensor to signal on. When tray level sensor on signal is detected by the control logic, the feed/lift motor begins to rotate in a clockwise (CW) direction, driving the nudger and feed rolls and thereby feeding the top sheet towards the takeaway rolls, **Figure 6**.

During paper feeding the tray level sensor is continuously monitored. When the signal tray level sensor signal off is detected, the control logic determines that it cannot feed the next sheet. The feed/lift motor, that is rotating CW during feed, then begins rotating CCW a predetermined time after the end of the feed operation. Thereby, recommencing elevation of the paper stack to the paper feed position, then the feed cycle begins again, **Figure 6**.

NOTE: This component configuration is typical for paper trays 1, 2, 3 and 4.

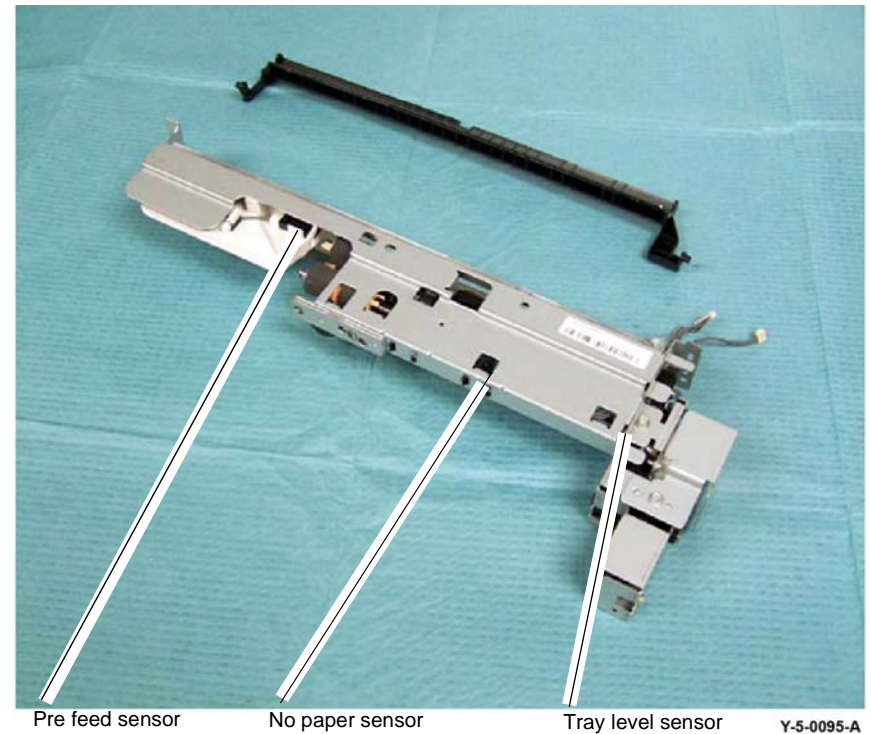
Figure 7 Feeder assembly

The tray level sensor, no paper sensor and pre feed sensor are all integral to the feeder assembly, **Figure 7**. The feed/lift motor is part of the feeder assembly, **Figure 8**. Only paper tray 1 has a pre feed sensor. This sensor is use to detect paper mis feeds and paper jams.

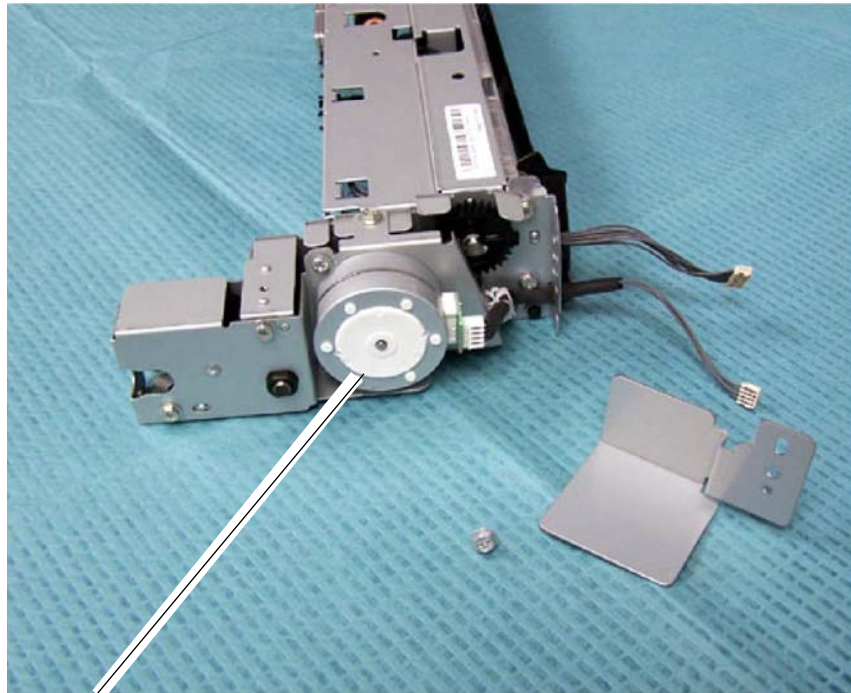
Feed/lift motor

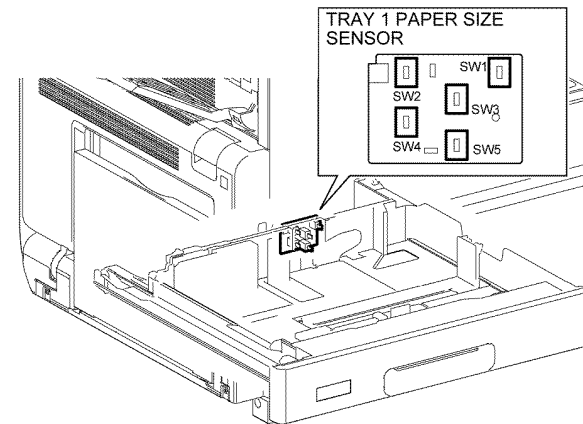
Figure 9 Paper size switch location

NOTE: Although Figure 9 depicts the tray 1 paper size sensor, the location of the sensor in relation to the paper tray is typical for paper trays 2, 3 and 4.

If a tray selected on the UI does not contain paper of the selected size, the machine will not print using that tray. If an analog to digital value that is not appropriate for the size of paper in a specific tray is detected the machine will not print using that tray.

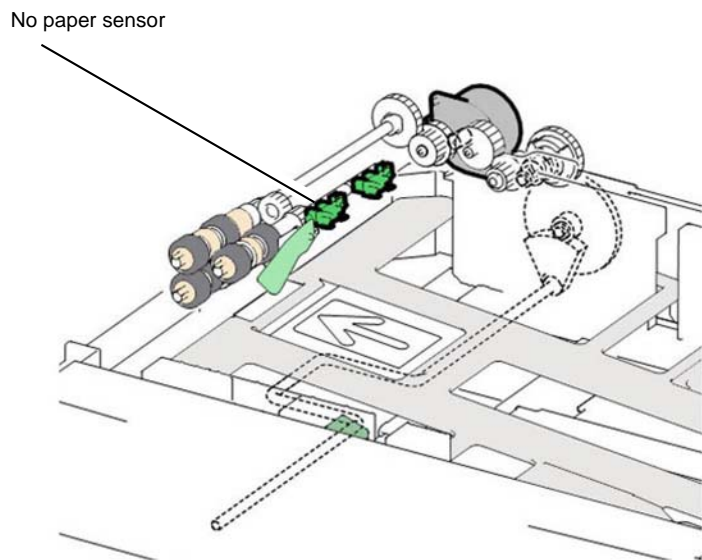
Figure 11 No paper sensor

Refer to [Figure 11](#). The no paper sensor detects if there is paper in the paper tray. The no paper sensors monitor every 0.01 second while the machine is in operation and at standby. When the last sheet feeds from the tray, the no paper sensor actuator drops into an opening in the paper tray bottom plate and unblocks the no paper sensor. This signals to the control logic that the tray is empty and to display a tray empty message on the UI.

If it is determined that a tray has no paper, the machine prohibits that tray from being used. If no paper is detected during feed, the machine will finish with the paper that is being fed and then stop. However, if the machine is in auto tray switch (ATS) mode and the same size of paper is found in another tray, the machine will start to feed paper from that tray.

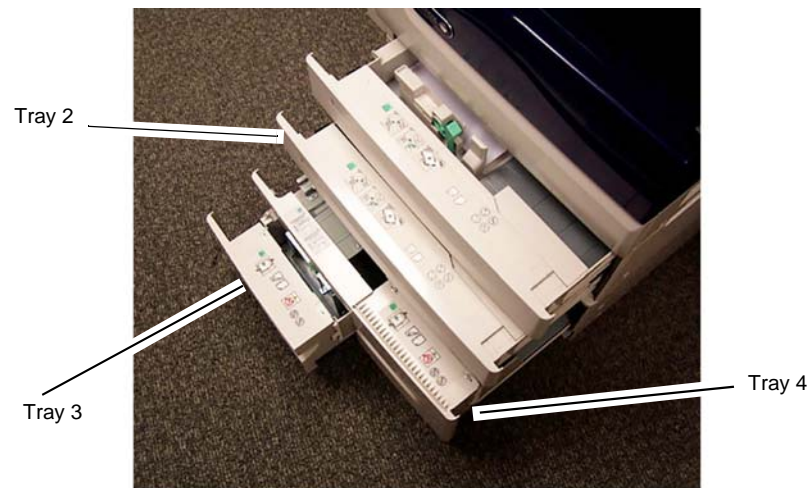
Figure 12 TTM tray 3 and tray 4

- Tray 3: 870 sheets of A4 or 8.5 x 11 inch paper.
- Tray 4: 1130 sheets of A4 or 8.5 x 11 inch paper

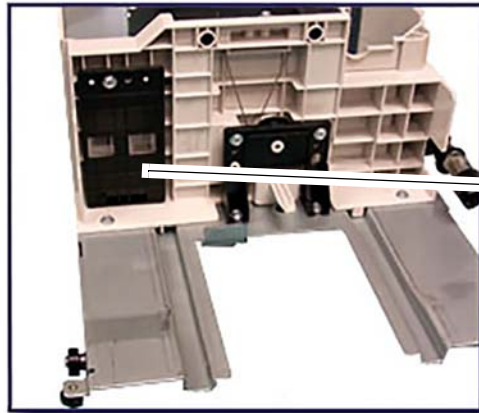
Tray 3 paper size sensor - The tray 3 paper size sensor detects if tray is inserted and senses paper size. The tray 3 paper size sensor contains two switches, [Figure 15](#). The size actuator, [PL 70.66 Item 2](#), mounted on the tray, that works with the tray side rear, [PL 70.66 Item 3](#), and the side front, [PL 70.66 Item 4](#), guides, presses these switches, [Figure 13](#). The combination of the on and off states of these switches changes the output voltage, based on which paper size is sensed.

The tray 3 size actuator is a thin, clear film sheet with cutouts; tray 4 is similar.

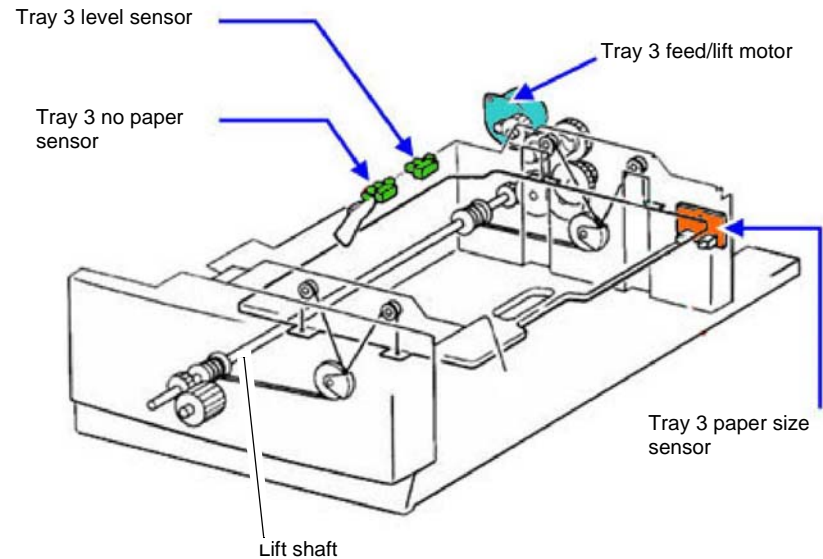
Figure 14 Tray 3 components

Tray 3 no paper sensor. The tray 3 no paper sensor detects that there is no paper in the tray. The sensor is monitored continually during run, at power on, and when the tray is inserted, [Figure 14](#).

Tray 3 Feed/lift motor. The feed/lift motor is a bi-directional stepping motor. When the motor rotates counter clockwise (CCW), it rotates the lift shaft through the gears and lifts the bottom plate. As it rotates clockwise (CW), it drives the nudger roll and the feed roll, [Figure 14](#).

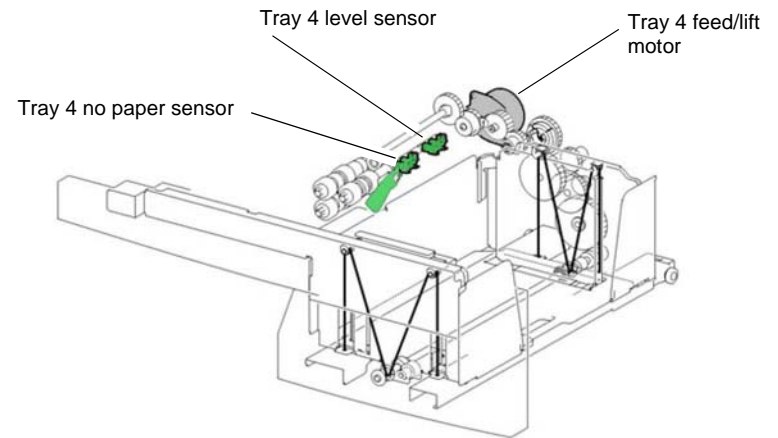
Figure 16 TTM tray 4 components

When the last sheet feeds from the tray, the tray 4 no paper sensor actuator drops into an opening in the paper tray elevator unblocking the tray 4 no paper sensor. This signals the control logic that the tray is empty and to display a (tray empty) message on the UI, [Figure 16](#).

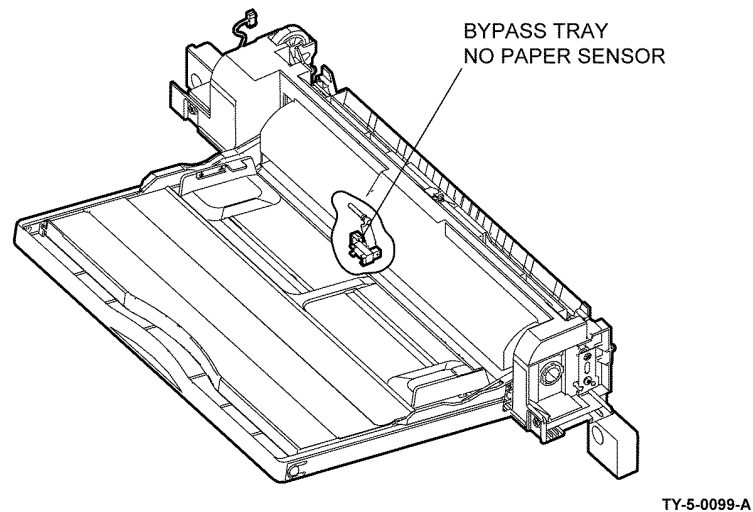
Figure 17 Bypass tray no paper sensor

Bypass tray no paper sensor - The bypass tray no paper sensor detects the presence of media. If the detected length of the media is greater than the size selected on the control panel or not within a range from 88.9 to 297mm, the machine stops, [Figure 17](#).

An actuator attached to the upper frame, [PL 70.35 Item 4](#), blocks the bypass tray no paper sensor when there is no media in tray 5. As paper is loaded in tray 5, the lead edge of the stack moves the actuator, unblocking the sensor. The bypass tray no paper sensor signal is monitored by the drive PWB, [PL 1.10 Item 3](#).

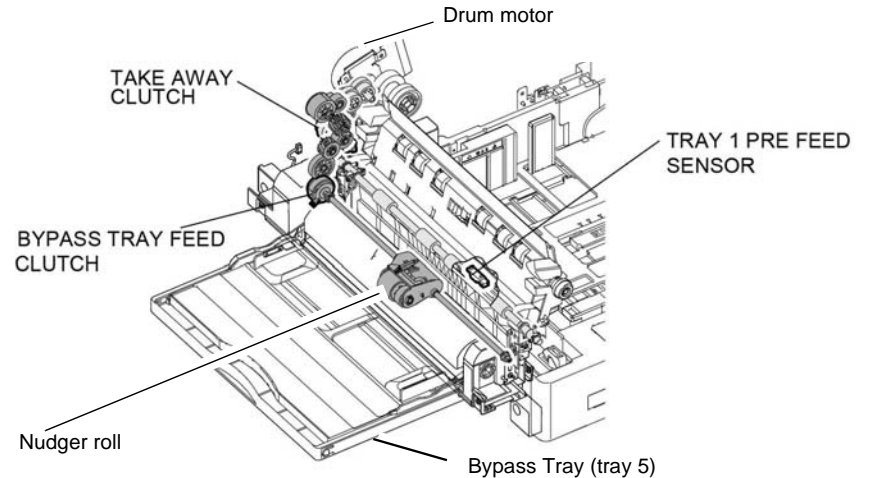
Figure 18 Bypass tray

When media is placed in the bypass tray the paper stopper is locked in the down position preventing media entering the paper path and the nudger roll is in a none media contact raised position, [Figure 18](#).

The bypass tray employs a friction retard pad, feed roll and nudger roll for media separation and feed. Drive for the bypass Tray is provided by the drum motor MOT42-002, [PL 40.10 Item 1](#), via a 3 gear train, [PL 40.05](#).

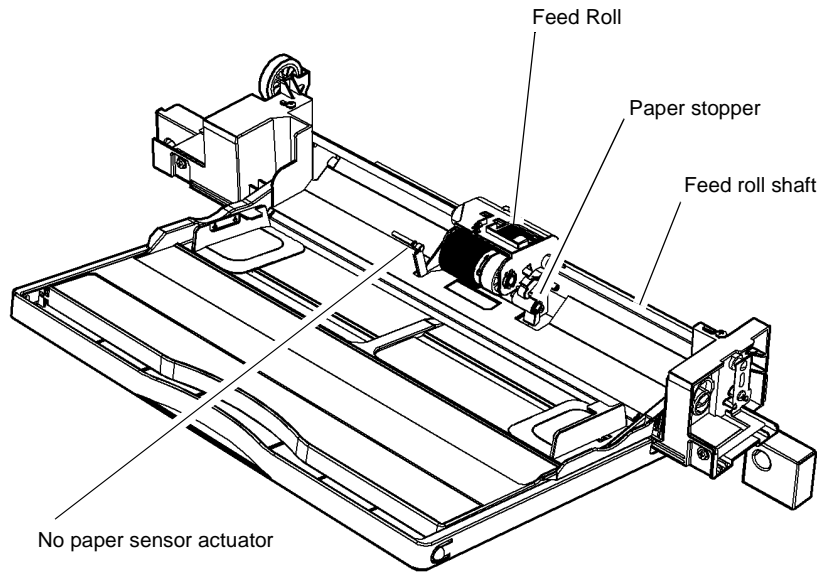
Figure 19 Bypass feed components

The bypass tray gear, [PL 40.05 Item 5](#), engages with the drive gear 22T, [PL 70.40 Item 5](#), that engages the bypass tray feed clutch. When energized, the bypass tray feed clutch transfers drive from the drive gear 22T to the shaft of the feed roll. In turn the feed gear 30T, [PL 70.40 Item 19](#), transfers motion to the nudger roll, [PL 70.40 Item 16](#), via the idler gear, [PL 70.40 Item 14](#), and nudger rear 37T, [PL 70.40 Item 15](#).

As drive is provided to the nudge roll lowers just enough to contact and pick up the media. The paper stopper is unlocked and media feed enabled, [Figure 19](#).

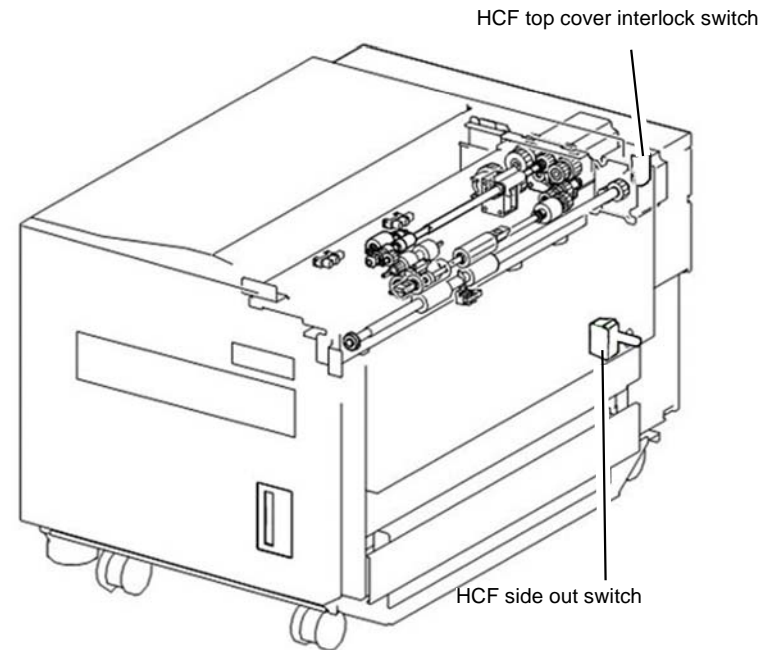
Figure 20 HCF Interlocks

Refer to [Figure 20](#). The HCF top cover interlock switch cuts +24VDC power to the K1 relay on the HCF PWB, [PL 70.60 Item 9](#), when opened, turning off the HCF feed/lift motor, [PL 80.60 Item 23](#), and the takeaway motor, [PL 70.60 Item 7](#).
