708P91370
April 2017

Xerox® VersaLink® B7025/B7030/B7035 Multifunction Printer Service Manual

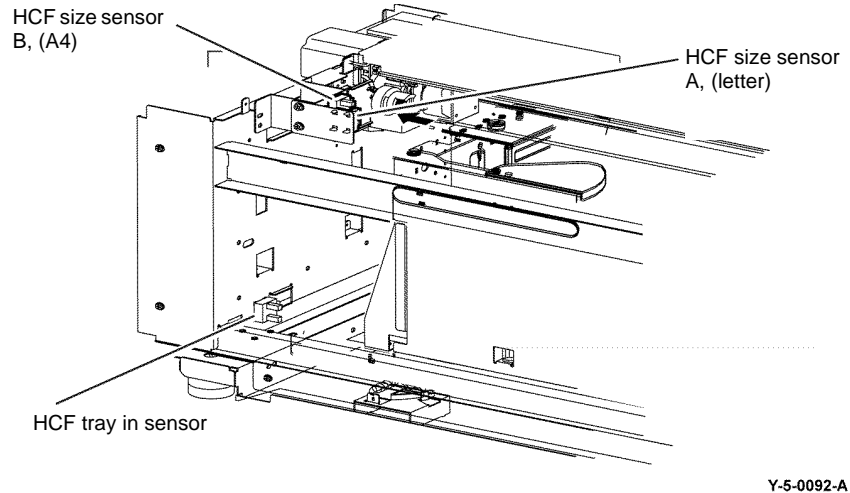
Figure 21 HCF tray in and paper size sensors

Refer to [Figure 21](#). The HCF tray in sensor detects that the HCF drawer is in the operating position. This prevents the HCF feed/lift motor, [PL 80.60 Item 23](#), from operating with the drawer open.

When the HCF tray is pulled out to load paper, the lift gear is separated from the drive gear and the tray is free to fall to the bottom position. A torque limiter on the lift shaft slows the fall of the paper tray to prevent damage to feeder components.

Size sensing is determined by the HCF size sensor (A) and the HCF size sensor (B). The paper tray guides actuate the size sensors, [Figure 21](#) and [Table 1](#).

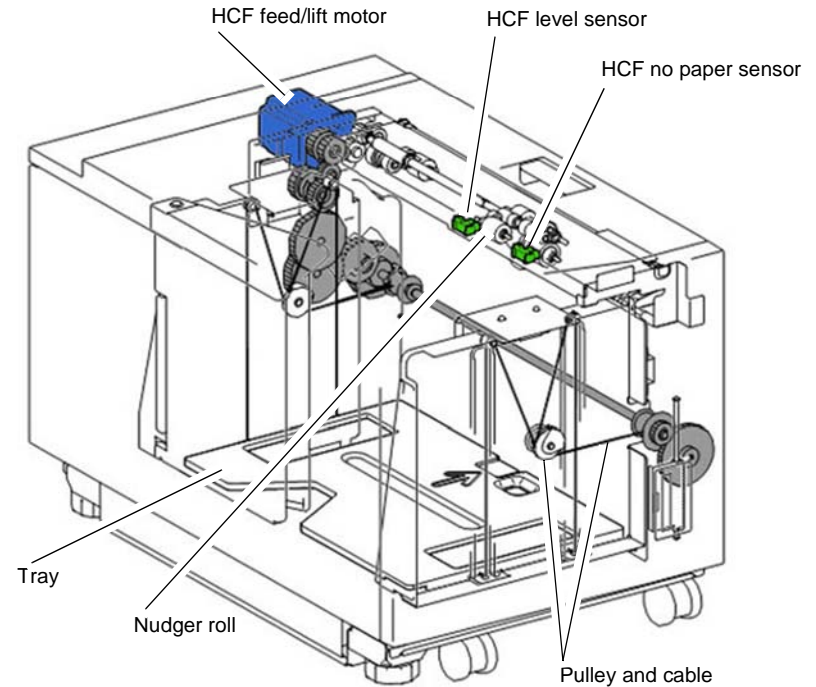
Figure 22 HCF level sensor

The control logic calculates the amount of paper that remains in the HCF tray by the time it takes for the paper stack to deactivate the HCF level sensor, [Figure 22](#). The value is then displayed on the UI for operator information. Refer to [Table 2](#) for the time/quantity relationship.

If the HCF is empty, the HCF no paper sensor will actuate, and a Tray Empty message will display, [Figure 22](#).

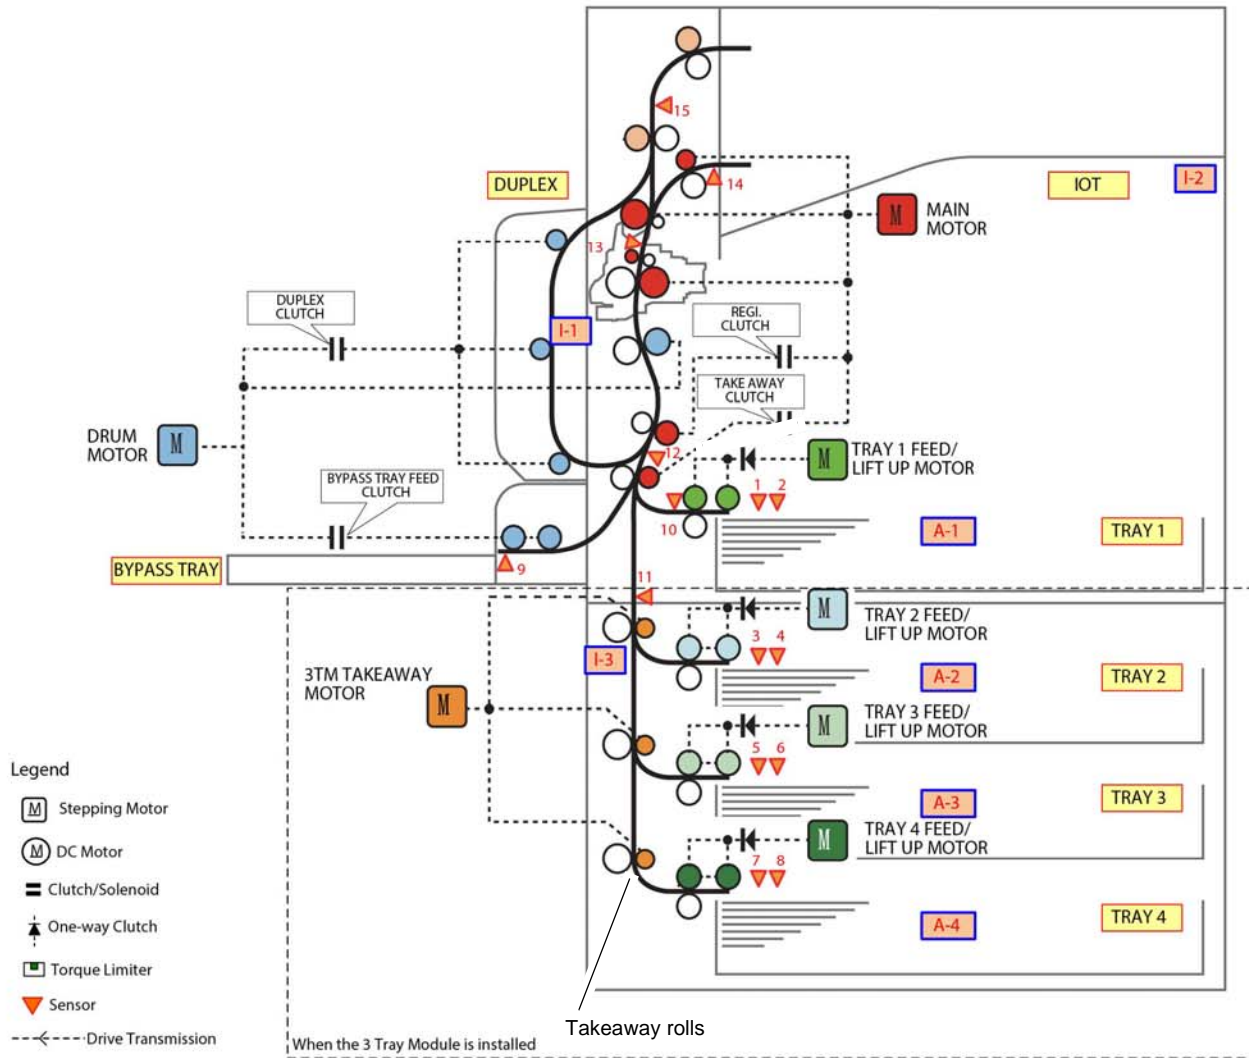
[Figure 1](#) shows the paper path, drive components and sensors of the Xerox® VersaLink® B7025/B7030/B7035 machine, configured with a 3 tray module (3TM).

Cover Switch

No.	Switch Name	CH
I-1	L/H COVER INTERLOCK SWITCH	1.8
I-2	FRONT COVER INTERLOCK SWITCH	1.8
I-3	3TM LEFT COVER SWITCH	1.9

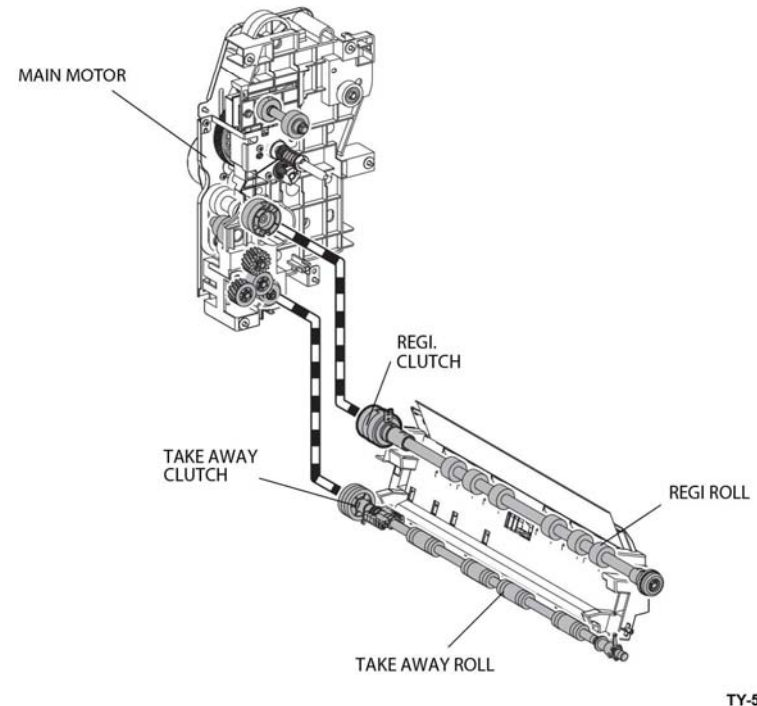
Figure 2 Tray 1 Takeaway and registration roll drive

The drive for the takeaway rolls is provided by the take away motor of the associated paper tray, with the exception of paper tray 1. The drive for the tray 1 takeaway roll is provided by the main drive motor, [Figure 2](#).

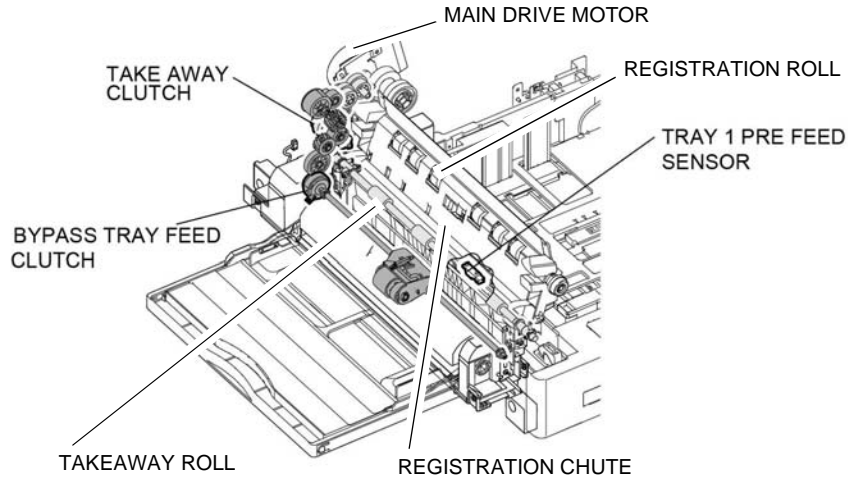
Figure 3 Tray 1 transport

When tray 1 is selected the takeaway clutch, PL 40.10 Item 5, is energized, thereby transferring drive via a gear from the main drive motor, PL 40.10 Item 1, to takeaway roll 1, PL 80.55 Item 15. At the same time the tray 1 feeder is activated and paper is fed from the feeder into the registration chute, PL 80.55 Item 2, and onwards to the registration roll nip via the takeaway roll, Figure 3.

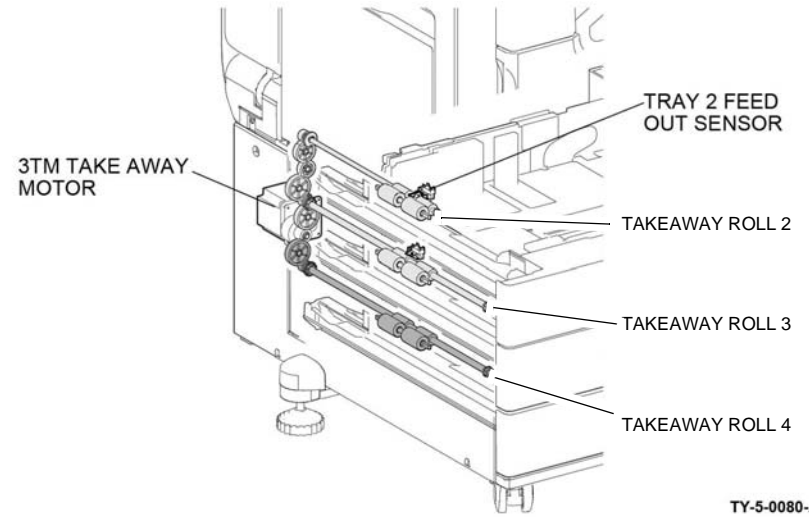
Figure 6 3TM takeaway

When feeding from tray 3 or tray 4 of a 3TM, the takeaway motors of all the above paper trays are energized and drive their associated takeaway rolls, Figure 6. At the same time the tray 3 or 4 feeder is activated and paper is fed from the feeder onto the associated takeaway roll (3 or 4). Trays 3 and tray 4 have no feed out sensors. The takeaway motors for trays 1, 2, 3 and 4 will stop when the registration sensor detects the lead edge of the final sheet in a print job.

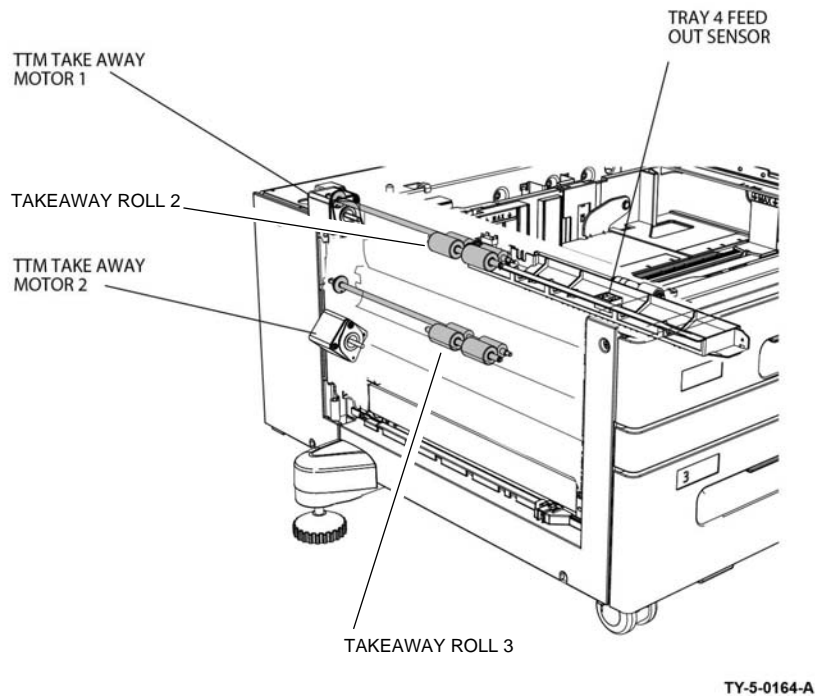
Figure 7 TTM

When tray 3 or tray 4 is selected tray 1 takeaway roll is driven by the main drive motor, tray 2 takeaway roll is driven by the takeaway motor 1. Takeaway roll 3, PL 80.65 Item 17, and the tray 4 transport roll, PL 80.70 Item 14, of the TTM are driven via their respective gear trains and a drive belt, PL 70.85 Item 10, linked to takeaway motor 2 (MOT77-035), PL 70.85 Item 2 and Figure 7. At the same time the tray 3 or 4 feeder is activated and paper is fed from the feeder onto takeaway roll 3. Paper feed from tray 4 is transported past the tray 4 feed out sensor to the tray 3 takeaway roll via the tray 4 transport assembly, PL 80.70 Item 11.

The paper continue transportation to the registration nip rolls via takeaway rolls 1 and 2. The takeaway motors for trays 1, 2, 3 and 4 will stop when the registration sensor detects the lead edge of the final sheet in a print job.

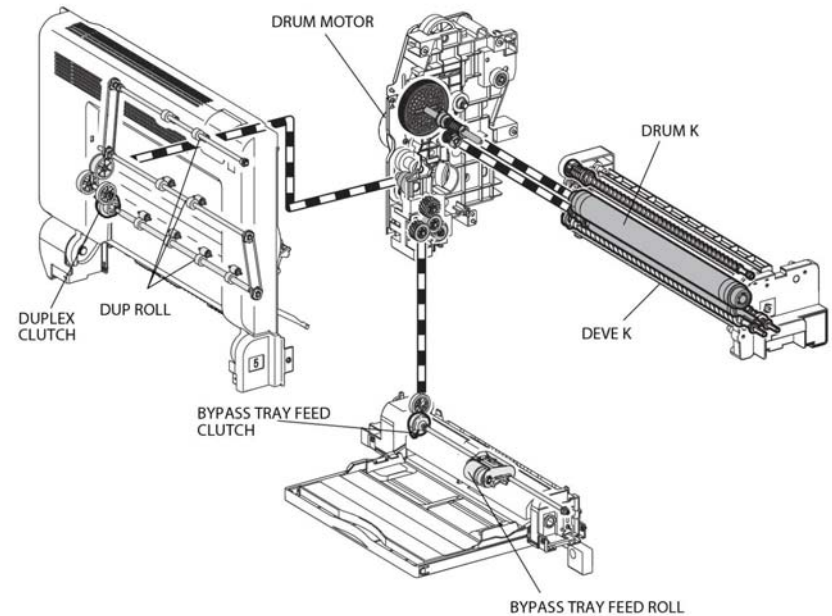
Figure 8 Drum motor

The drum motor (MOT42-002), PL 40.10 Item 1, provides in direct drive to the bypass tray, drum cartridge and the duplex rolls, Figure 8.

The idlers for the registration roll, [PL 80.55 Item 8](#), are located in the LH cover assembly, [PL 80.45 Item 1](#), and with the registration roll form the registration nip. The registration roll is driven by the main motor via a gear train and registration clutch, [PL 80.55 Item 11](#). As the registration roll receives the paper that has been fed from the paper trays a buckle is formed in each sheet as it reaches the registration nip to remove any skew. At this point there is a small delay for sheet scheduling. After this time has expired, the registration clutch is energized and the main motor and registration roll are run to transport the sheet between the BTR roll and the photoreceptor in the xerographic transfer area. As the sheet passes the the drum of the photo receptor the toner image is transferred to the paper, refer to [Figure 8](#) and [Figure 9](#).

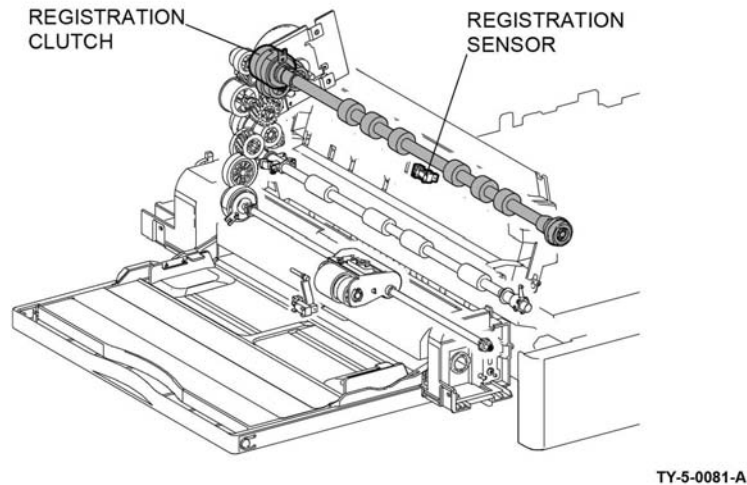
Figure 9 Paper registration

The registration sensor detects the paper just prior to the registration nip rolls. Its signal, in conjunction with the registration clutch on signal, indicates media jams, i.e., if the registration clutch on signal has occurred and the sensor fails to stay on a specified time, a jam downstream from the sensor or in the duplex path is indicated and the paper path transport system will shut down. The control logic also uses the signal from the registration sensor (registration sensor off) in the control of duplex transport operations, bypass feed start timing, and tray 1 feed start timing, [Figure 9](#).

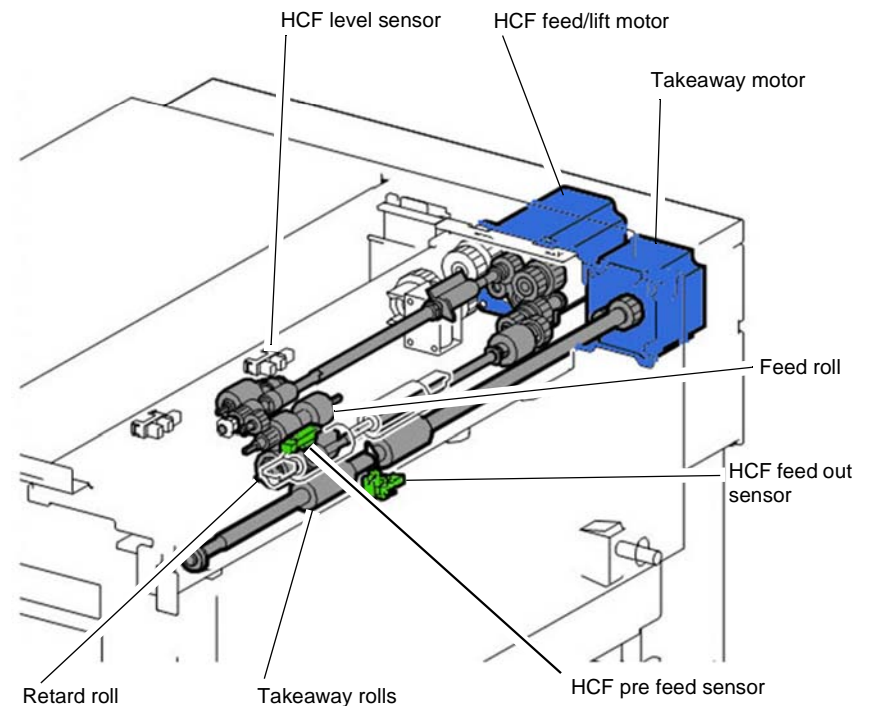
Figure 10 Paper feed

- The HCF feed/lift motor switches on in a clockwise direction, rotating the nudger roll and feed rolls.
- The top sheet feeds into the nip of the feed roll and retard roll, actuating the HCF pre feed sensor; this turns on the takeaway motor.
- Paper continues to advance, actuating the HCF feed out sensor.
- The takeaway motor rotates the takeaway rolls, transporting the sheet to the takeaway rolls in the IOT's takeaway (vertical) transport.
- When the trail edge of the paper clears the HCF feed out sensor, a timed interval begins after which the takeaway motor switches off.
- As paper continues to feed from the paper stack, the HCF level sensor will de actuate, causing a lift cycle. The HCF lift/feed motor will switch off to stop feeding, then begin rotating counter clockwise to lift the paper stack, then the feed cycle will then begin again.

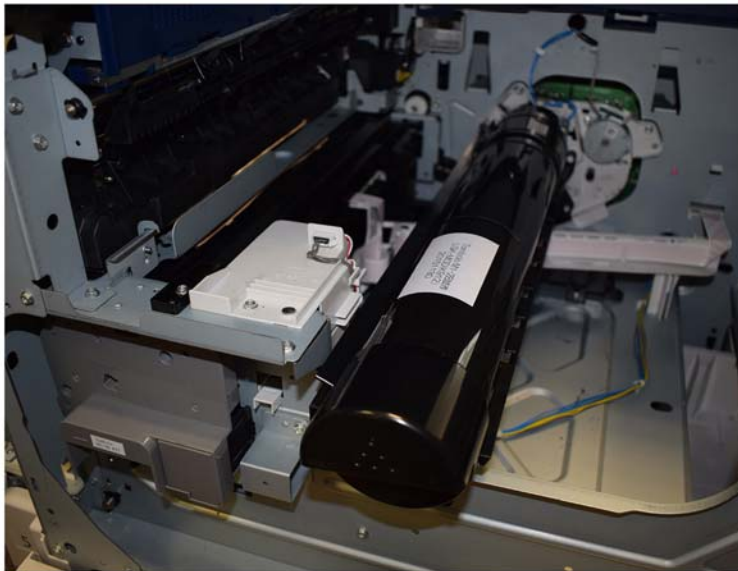
Figure 1 Main xerographic components

The print engine uses the following components in the xerographic process, refer to Figure 1.

- Toner cartridge (customer replaceable unit).
- Toner dispenser assembly.
- Drum cartridge (customer replaceable unit).
- Laser Print Head (LPH).
- Bias Transfer Roller (BTR) (customer replaceable unit).
- HVPS.

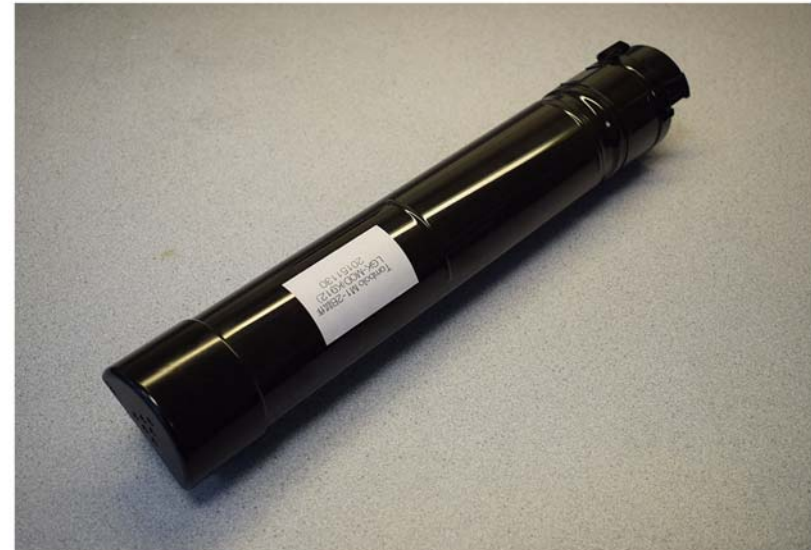
Figure 2 Toner Cartridge

The toner cartridge is a customer replaceable unit (CRU) with sufficient toner capacity for up to 30 000 feeds. Refer to Figure 2.

- Pre-Near End-of-Life: the toner cartridge is approximately 25% full
- Near End-of-Life: the dispense motor is on but the ATC sensor detects no increase in toner in the drum cartridge.
- End-of-Life: the ATC sensor detects no toner in the drum cartridge. The machine hard stops at this point.

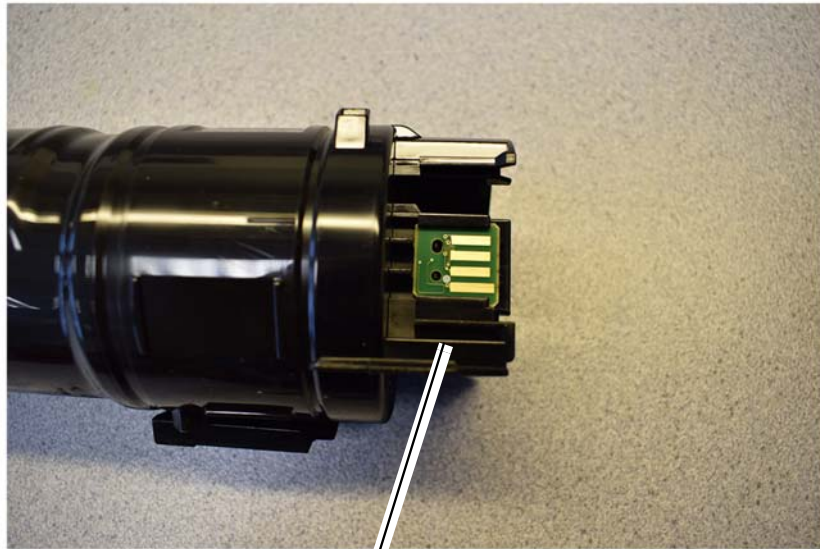
Toner cartridge CRUM PWB

The CRUM consists of two components - a CRUM Tag and a CRUM PWB. The CRUM PWB for the toner cartridge is mounted on the toner dispense drive, PL 90.10 Item 2 at the rear of the toner cartridge. Refer to Figure 3.

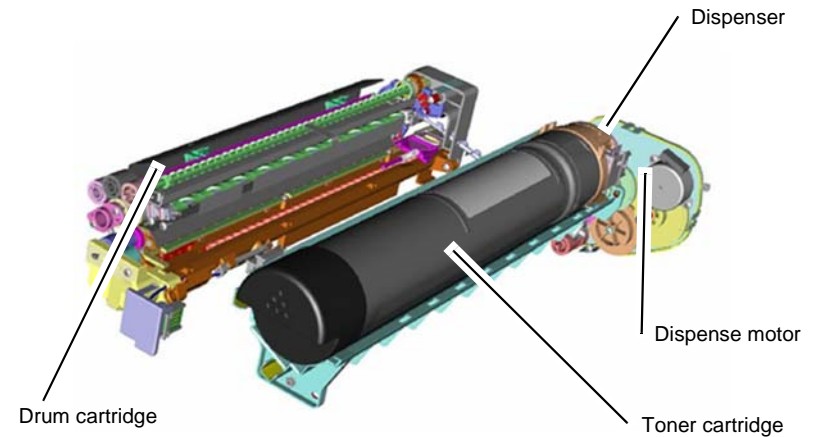
Figure 4 Dispenser assembly

The toner is transported from the toner cartridge to the drum cartridge by a dispenser which contains an auger. The dispenser is driven through gears by the dispense motor under the control of the automatic toner control (ATC) system.

The dispense motor also drives an agitator in the toner cartridge to stir the toner. Refer to Figure 4.

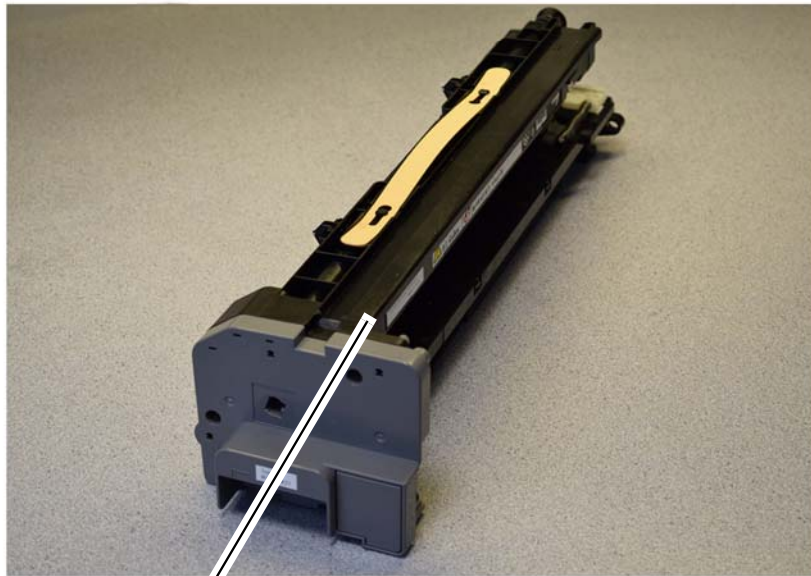
Y-5-0145-A

- photoreceptor drum
- Bias charge roll (BCR)
- Developer roll
- Augers (supply and toner reclamation/cleaning augers)
- Automatic toner control (ATC) sensor
- Drum cartridge CRUM

Drum cartridge

Refer to [Figure 5](#).

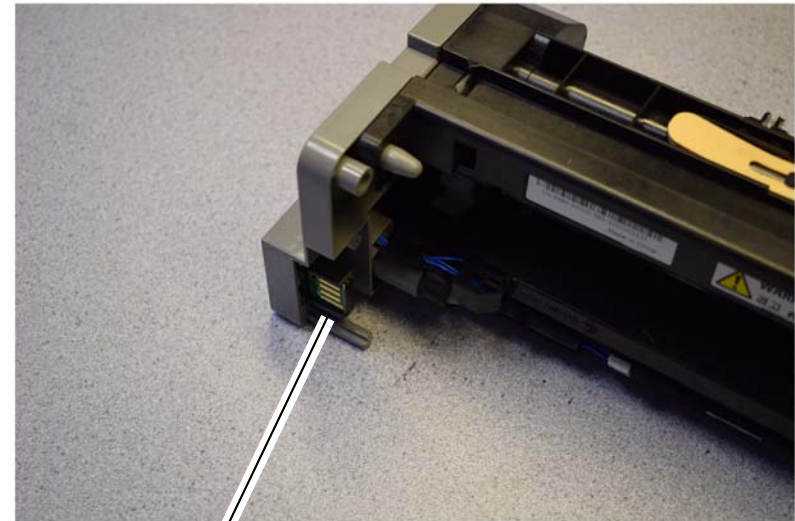
Y-5-0146-A

The CRUM consists of two components - a CRUM Tag and a CRUM PWB. The CRUM PWB for the drum cartridge is mounted at the front of the cartridge. Refer to [Figure 6](#).

Drum cartridge CRUM PWB

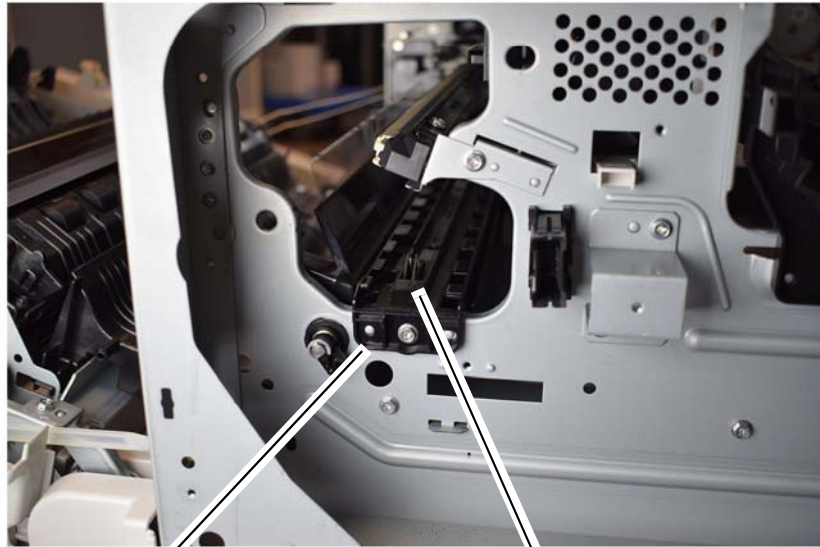
Figure 7 Drum cartridge guide electrical contacts

The high voltages required by the drum cartridge for charge and development are provided by the high voltage power supply (HVPS), [PL 1.10 Item 2](#), through two high voltage contacts on the guide assembly that supports the cartridge. Refer to [Figure 7](#), [Figure 8](#) and [Figure 9](#).

Drum cartridge guide assembly

Developer bias high voltage contact

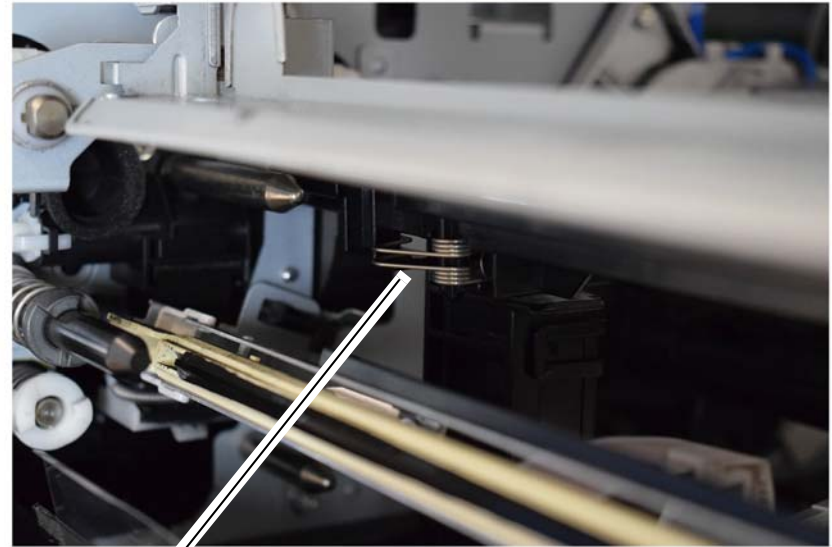
Figure 8 Drum cartridge guide electrical contacts

BCR (charge) high voltage contact

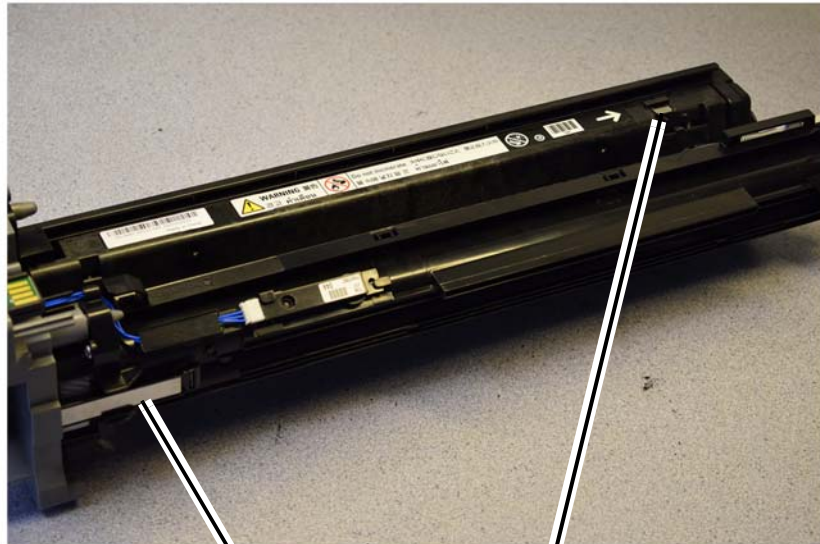
Developer bias high voltage contact

BCR (charge) high voltage contact

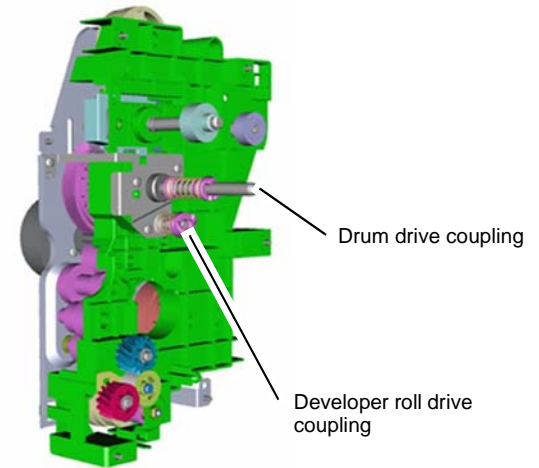
The rotation of the photoreceptor drum drives the waste toner auger which returns used toner to the drum cartridge housing. The rotation of the developer roll provides drive to the supply auger. Refer to Figure 10.

Drum drive coupling

Developer roll drive coupling

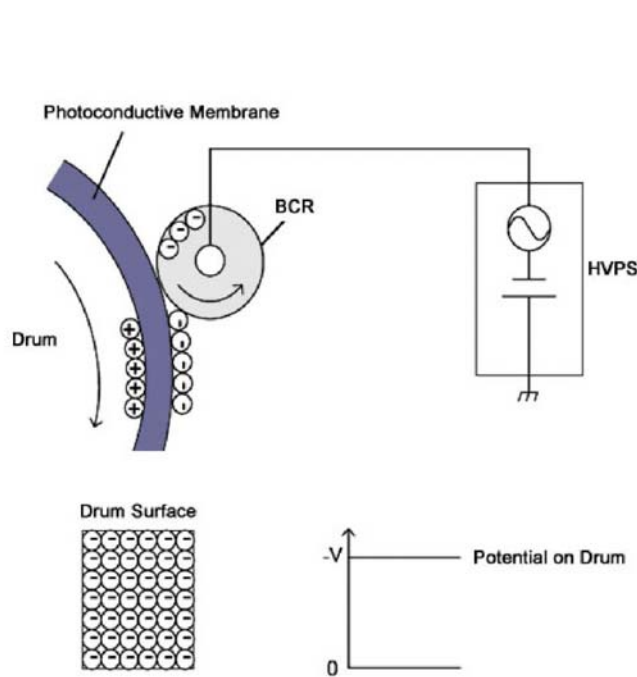
Figure 11 Photoreceptor drum charging

The bias charge roll (BCR) is in constant contact with and rotates with the photoreceptor drum. It applies a uniform negative DC voltage charge superimposed with AC voltage on the surface of the photoreceptor, preparing it to be exposed by the laser print head (LPH).

The surface of the drum is a light-sensitive, dispersion undercoat (DUC) membrane. After the photoreceptor's surface receives a uniform charge from the bias charge roller, the LPH exposes (discharges) the image areas. Refer to [Figure 11](#).

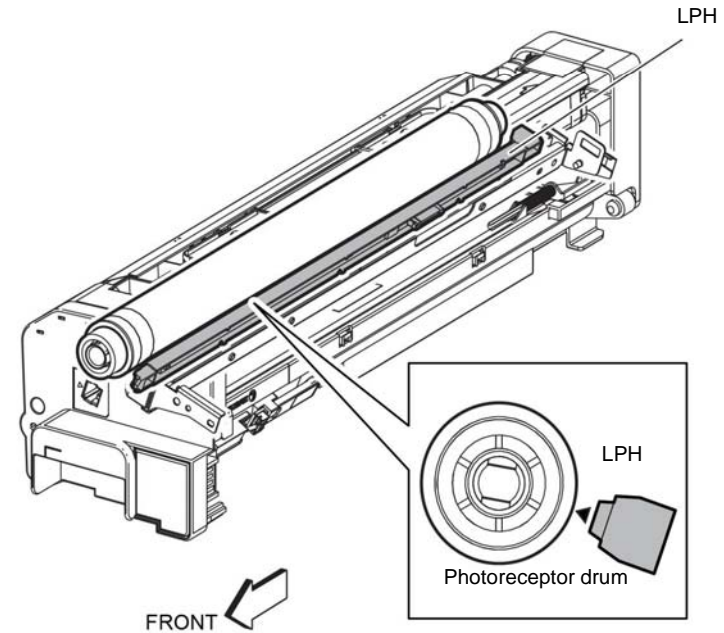
Figure 12 Laser print head (LPH)

The lasers are switched on and off based on the image density data from the ESS PWB and the laser light is directed onto the surface of the photoreceptor. The regions of the photoreceptor that are exposed by the laser become discharged, forming the electrostatic latent image that attracts the toner. Refer to [Figure 12](#).

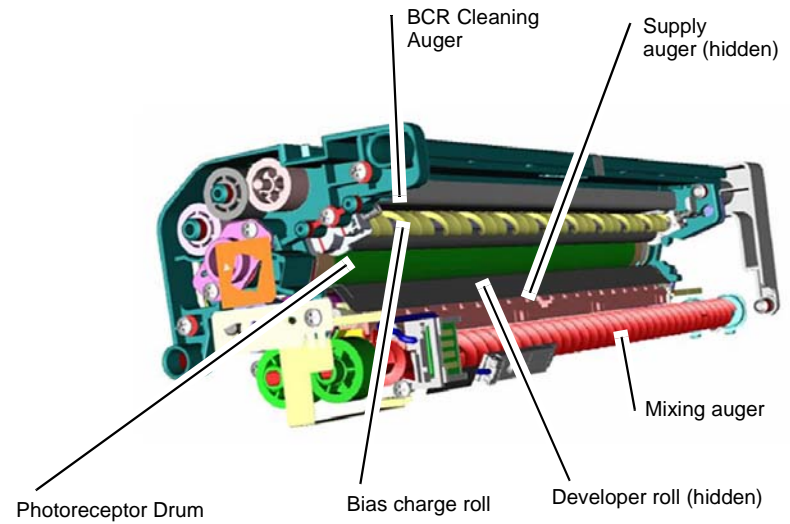
Figure 14 Drum cartridge developer components

The developer roll has a magnetic core which causes a brush to form at its surface. The height of the brush is controlled by the trimmer blade. The brush contacts the photoreceptor drum and the toner is attracted to the latent image formed by exposure to the LPH, that is, to the areas that have a reduced negative charge.

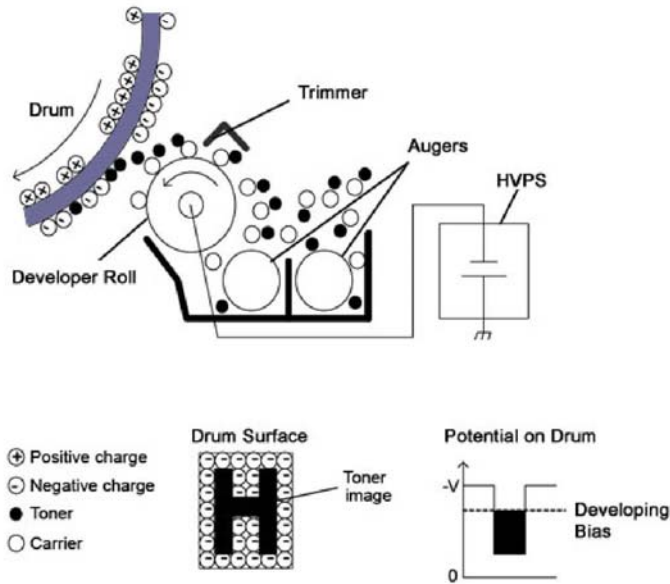
Figure 13 Drum cartridge development principle

A developer bias voltage that is applied to the developer roll controls the development process and gives cleaner background areas. The developer bias voltage is modified based on the user's selections on the UI. Darker images require a greater amount of negative charge to be applied than lighter images. Refer to [Figure 13](#) and [Figure 14](#).

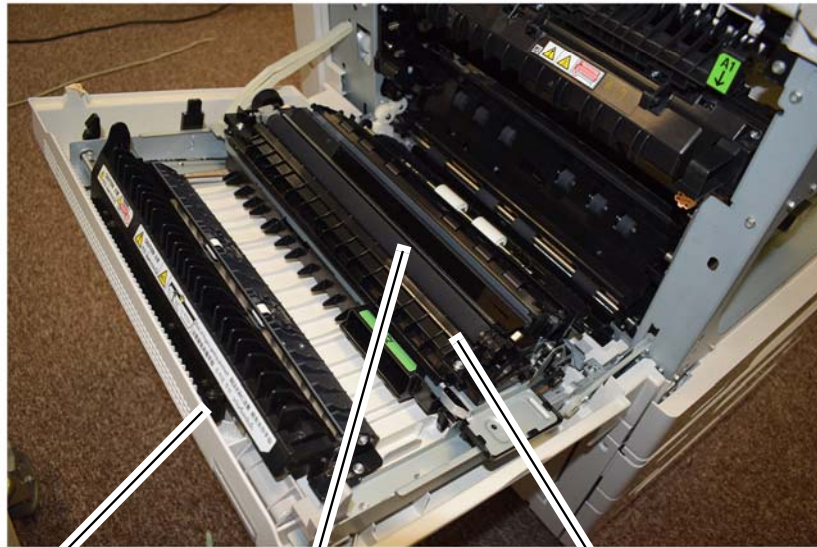
Figure 15 Bias transfer roll

L/H cover

Bias transfer roll

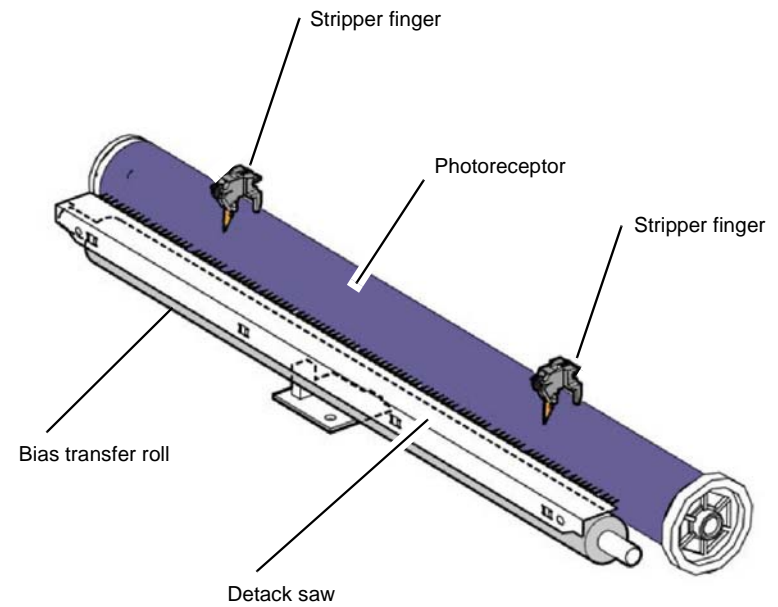
Figure 16 BTR detack

The paper is released from the photoreceptor drum by the detack saw and stripper fingers. A voltage is applied to the detack saw to eliminate the charge on the paper. In cases where the paper is still attracted to the photoreceptor drum, the stripper fingers will physically strip the paper from it. Refer to [Figure 15](#) and [Figure 16](#).

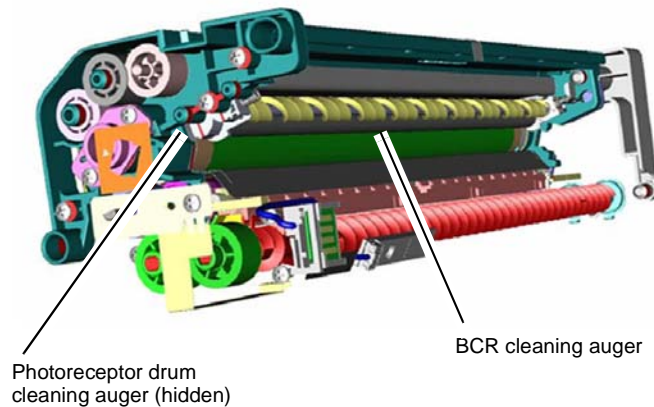
Figure 17 Photoreceptor drum and BCR cleaning

As the photoreceptor drum and BCR rotate their surfaces are cleaned by the cleaning augers. The auger strips used toner from the photoreceptor drum and BCR following transfer and transports the used toner to a port at the rear of the drum cartridge for reuse.

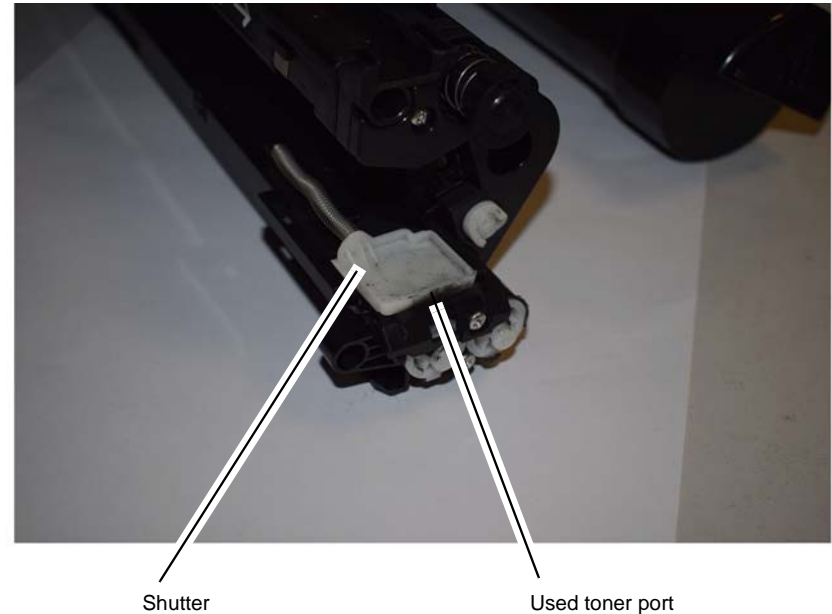
Figure 18 Used toner port and shutter

A shutter adjacent to the used toner port retracts when the cartridge is installed. It is here that fresh toner enters the cartridge. Refer to [Figure 17](#) and [Figure 18](#).

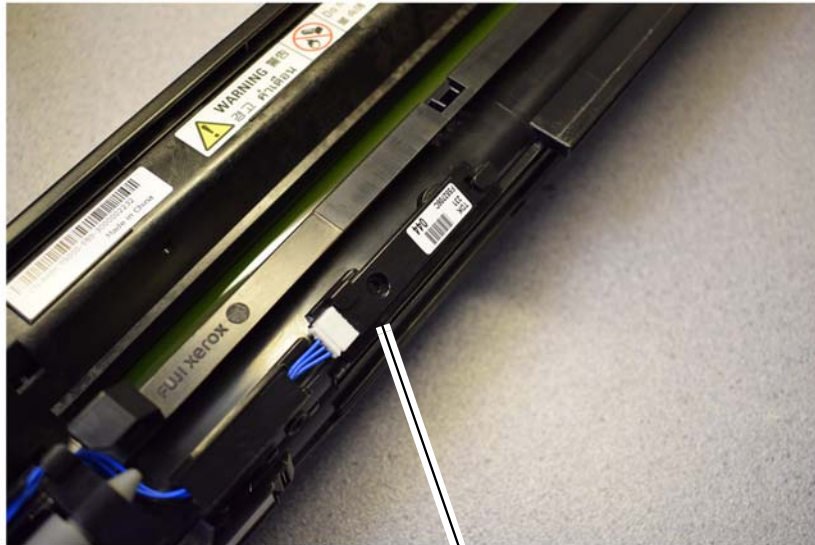
Y-5-0152-A

After an ATC sensor check, the ATC target value is calculated. To calculate the ATC target value, the temperature and humidity correction values calculated from the temperature and humidity in the machine and the developing material deterioration correction value calculated from the cumulative drum rotation time are added to the standard ATC target value. Refer to [Figure 19](#).

ATC sensor

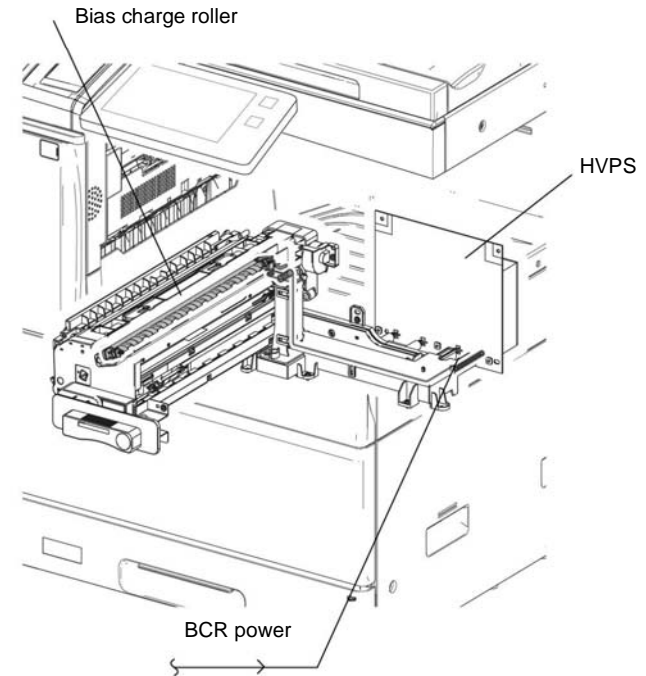
Figure 20 Charge control

Charge control corrects the charge voltage (the BCR output). Charge control correction factors include temperature and humidity and the cumulative number of drum rotations. These values are added to calculate the charge voltage correction value. Charge control occurs at the following times:

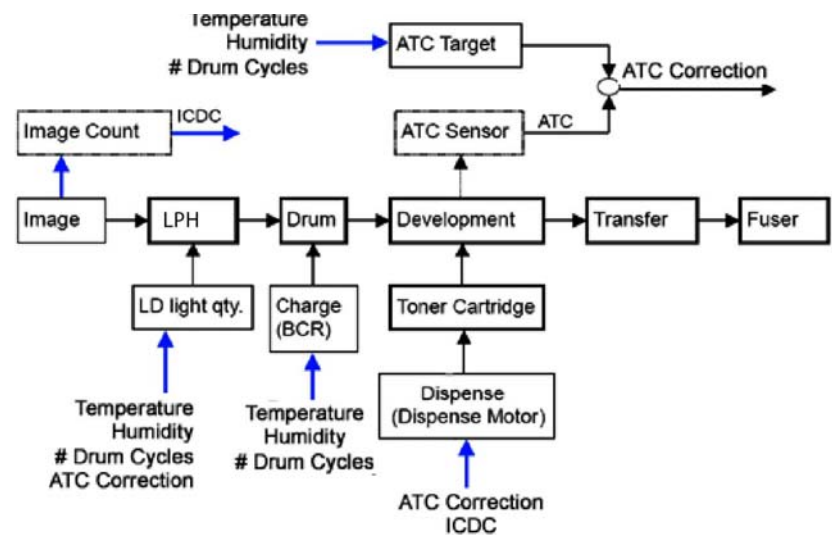
Figure 22 Toner dispensing control

NOTE: Toner dispense may be set in the NVMs to timed dispense, ICDC dispense, or dispense based on ATC control. When either timed or ICDC dispense is selected, ATC faults will not be reported but TC will be out of control. The preferred (default) setting allows Toner Control to manage dispense.

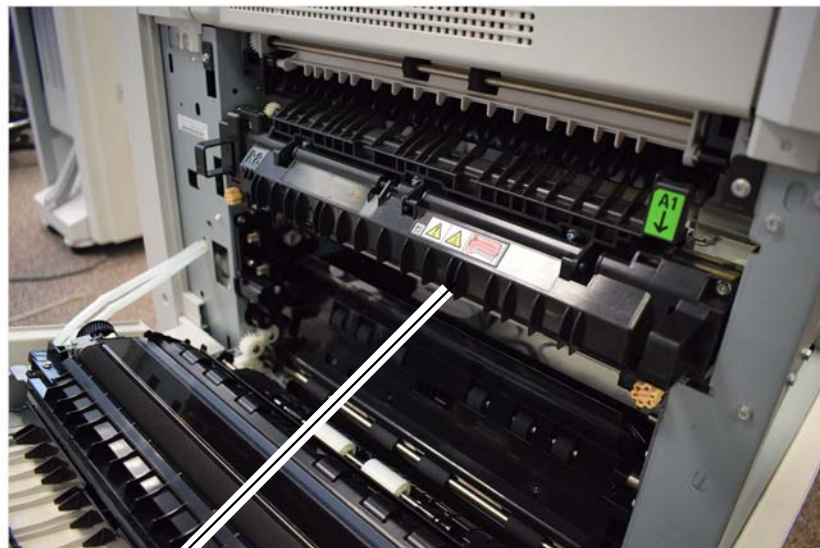
Y-5-0167-A

NOTE: There are no spare parts in the fuser assembly. The fuser is replaced as an assembly.

Fuser

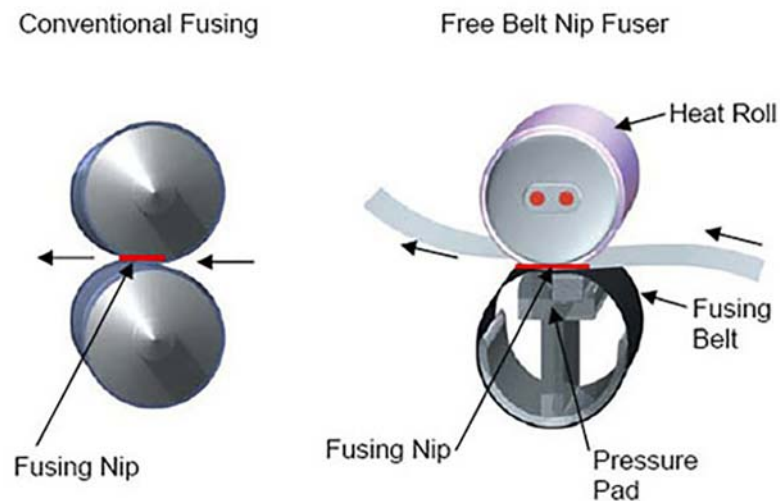
Figure 2 Free belt nip fuser

Fusing works using a free belt nip fusing mechanism consisting of a heat roll, and with a fusing belt in place of a pressure roll. The heat roll consists of a thin steel tube coated with teflon to control the build-up of static and an anti-wear agent. The heat roll and fuser belt are in constant contact during fusing, [Figure 2](#). The stripper blade physically removes the paper from the heat roll during processing. The heat roll receives drive from the main motor through a system of gears. The fusing belt is driven by the friction applied from the heat roll.

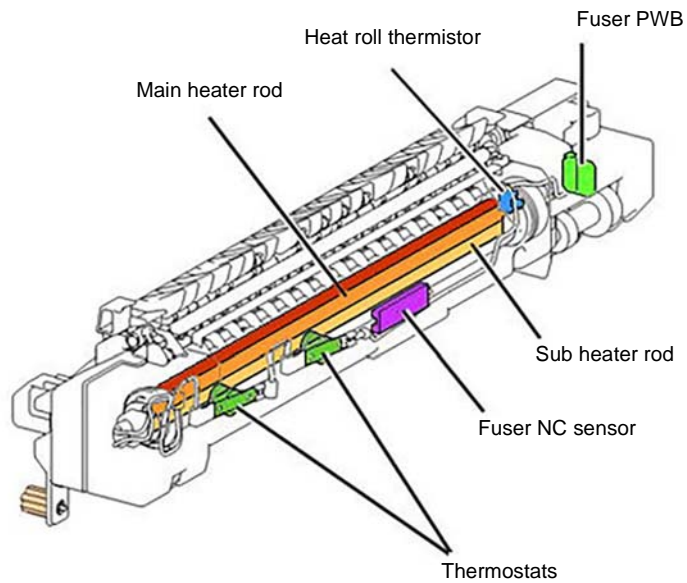
Figure 3 Fuser main components

The fuser temperature control is managed by two thermostats, the fuser non-contact (NC) sensor and the fuser thermistor, [Figure 3](#).

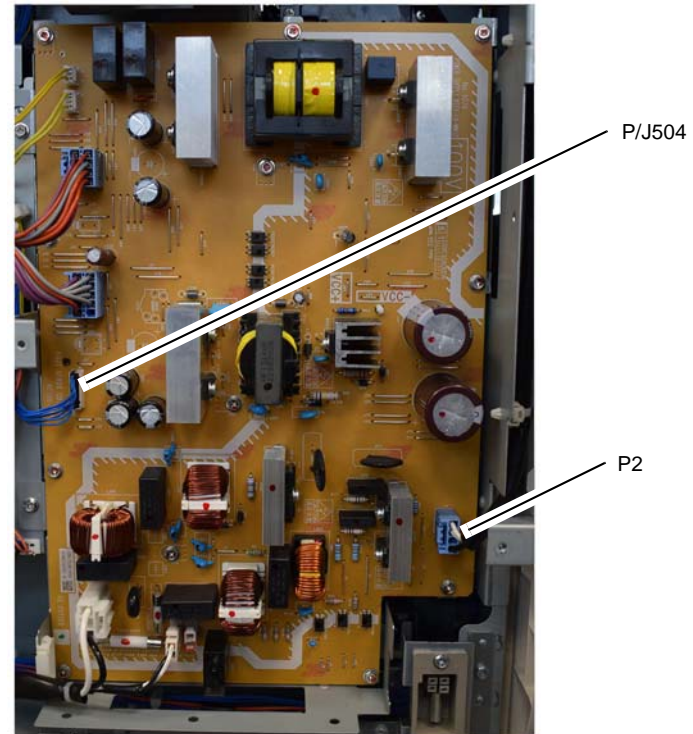
Figure 4 Fuser power (LVPS)

Main and sub heater on signal is supplied from P/J419 on the drive PWB, PL 1.10 Item 3 to P/J504 on the LVPS, PL 1.10 Item 8. With the fuser relay energized, power is supplied from P2 on the LVPS, Figure 4, to the fuser power connector, Figure 5. Refer to [BSD 10.1 Fusing Heat Control \(1 of 2\)](#).

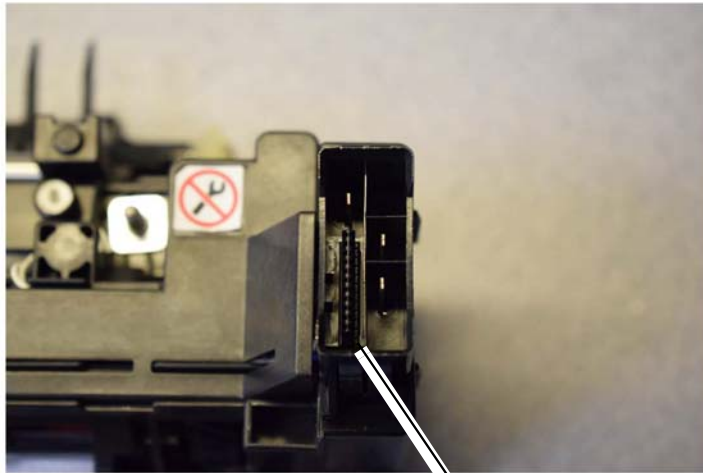
Y-5-0171-A

Fuser connector

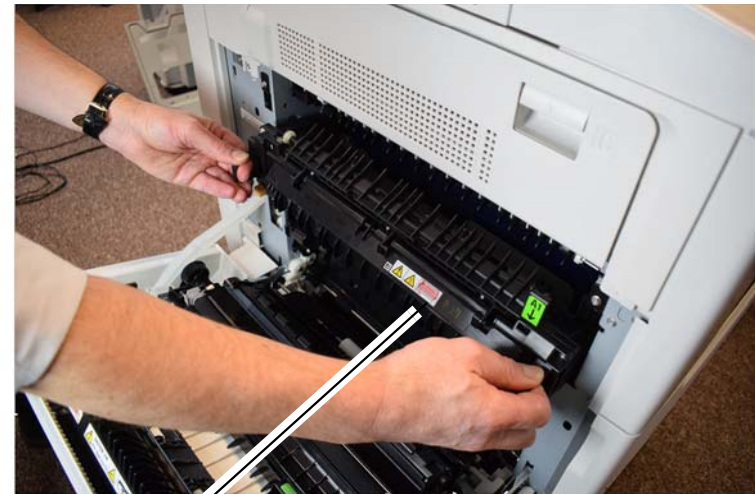
Figure 6 Fuser replacement

After installing a new fuser, the HFSI counters must be reset to zero in UI diagnostics.

Fuser

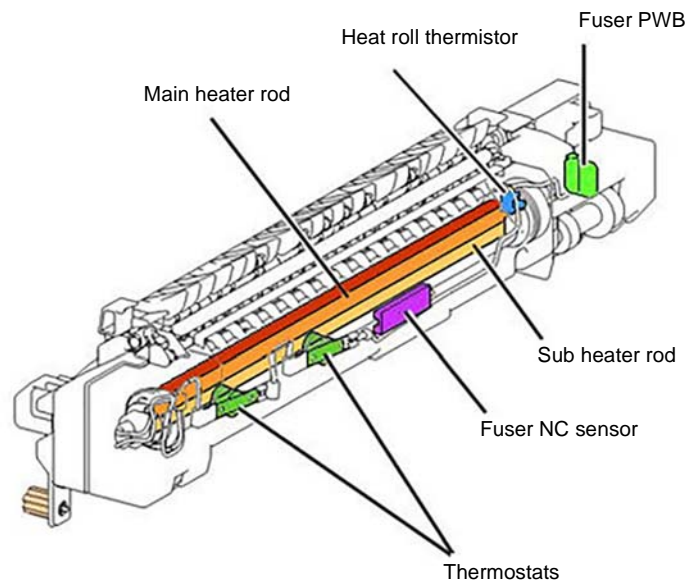
Figure 7 Fusing temperature control

The thermostats, located near the center and the front of the heat roll, provide over temperature protection. When the surface temperature of the heat roll exceeds a predetermined value, the thermostat opens, de-energizing the fuser relay and cutting off the current to the heat rods, refer to [BSD 10.1 Fusing Heat Control \(1 of 2\)](#), [Figure 7](#).

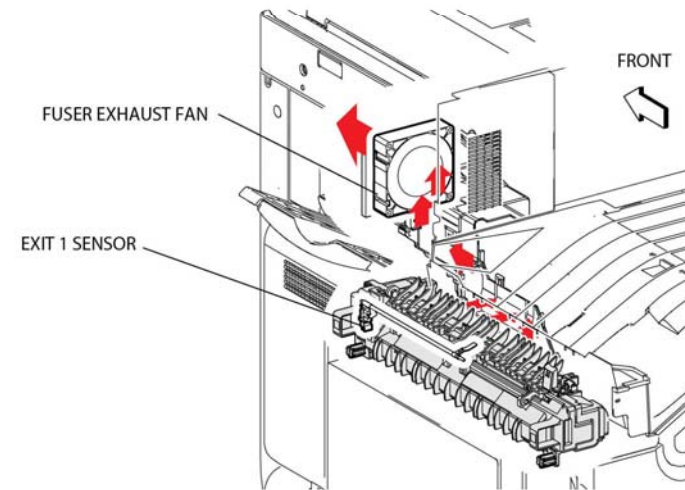
Figure 8 Fuser cooling ducting

The fuser fan, [PL 40.15 Item 4](#), exhausts heated air from the fuser area via the ducting. Refer to [Figure 8](#) and [Figure 9](#).

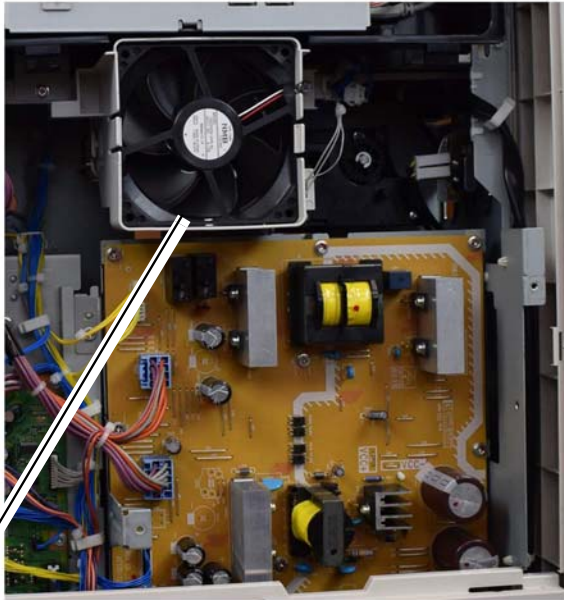
Figure 9 Fuser cooling fan

Fuser fan

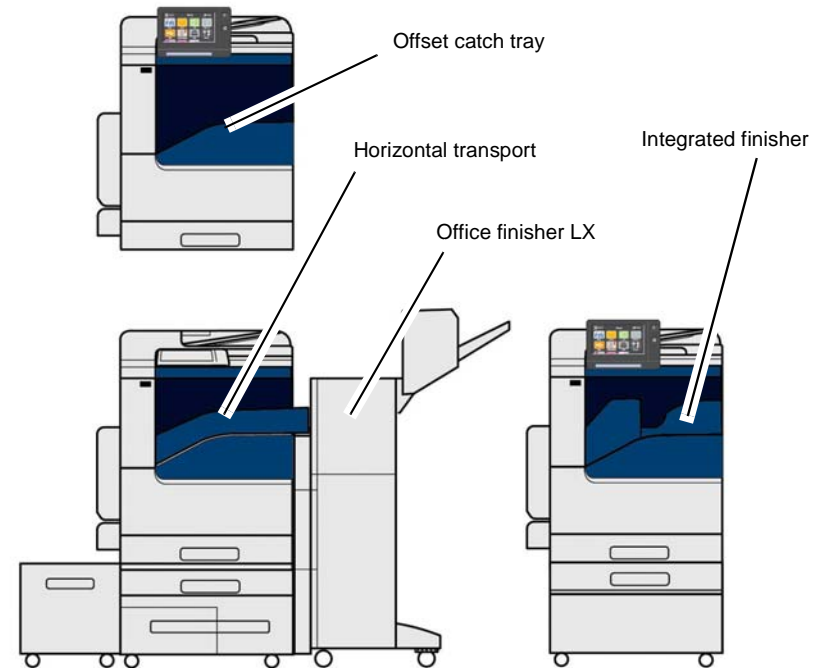
Figure 10 Finisher configurations

- To the output catch tray (exit 1) as single sheets or offset stacks.
- The integrated office finisher (exit 1).
- The horizontal transport (exit 1) to the office finisher LX.
- To the centre catch tray (exit 2) as single sheets or offset stacks.
- To the inverter (exit 2) for side two registration and printing.
