708P91370
April 2017

Xerox® VersaLink® B7025/B7030/B7035 Multifunction Printer Service Manual

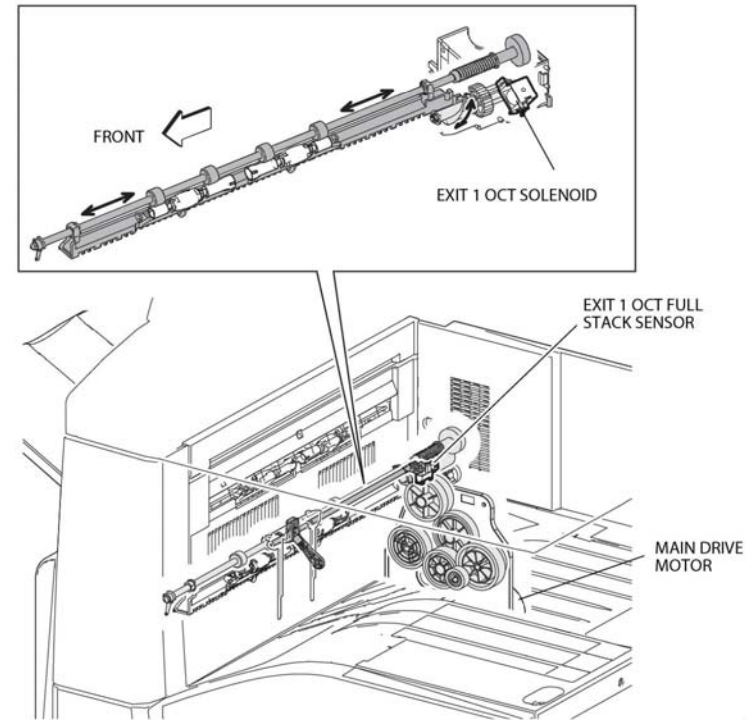
Figure 12 Exit 1 stacking

The exit 1 OCT solenoid moves the exit 1 roller toward the front or rear to offset the sheet or set. The exit 1 OCT full stack sensor monitors the position of the exit 1 roller.

Drive for the exit 1 roller is obtained from the main motor through a system of gears. Refer to [Figure 12](#).

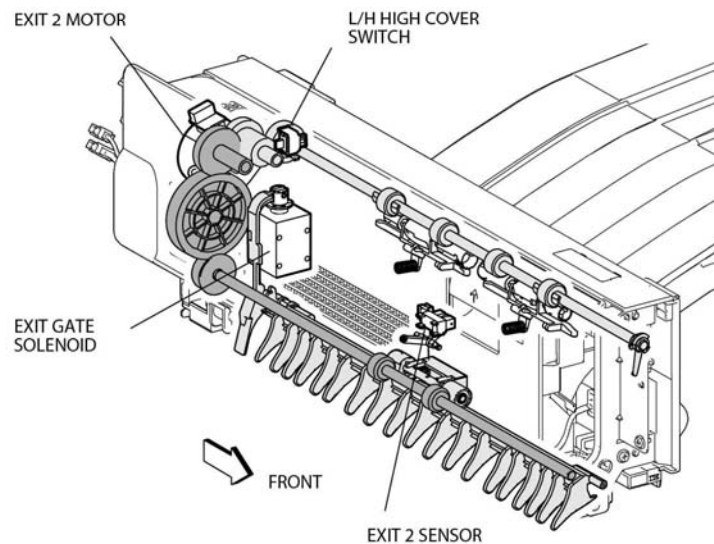
Figure 13 Exit 2

The signal from the fuser exit sensor, assists in controlling the operation of the exit 2 motor (stop and reverse timing) and actuation of the exit gate solenoid, both for duplex printing. Its signal also enables the control logic to count finished prints. The signal from the exit 2 sensor, [PL 10.22 Item 12](#), is used for jam detection in the exit area and to monitor completed prints as they exit to exit 2 Refer to [Figure 13](#)

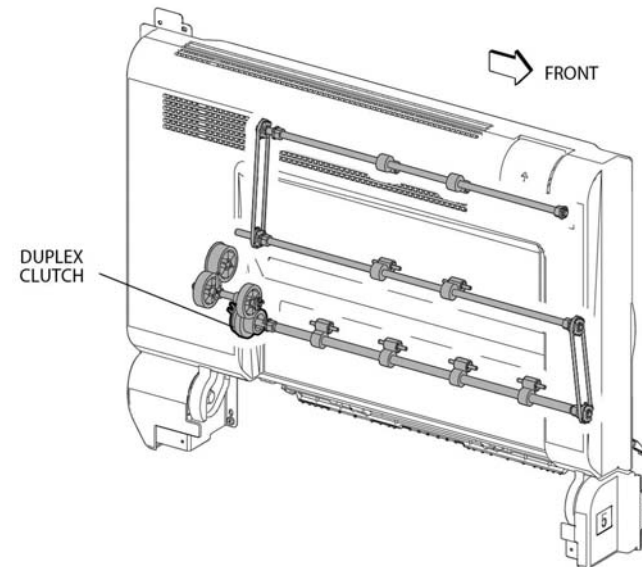
Figure 14 Duplex printing

After the trail edge of the sheet passes the diverter gate, the paper is inverted, drawn into the duplex path, and returned to the registration unit for side 2 printing. Refer to [Figure 14](#)

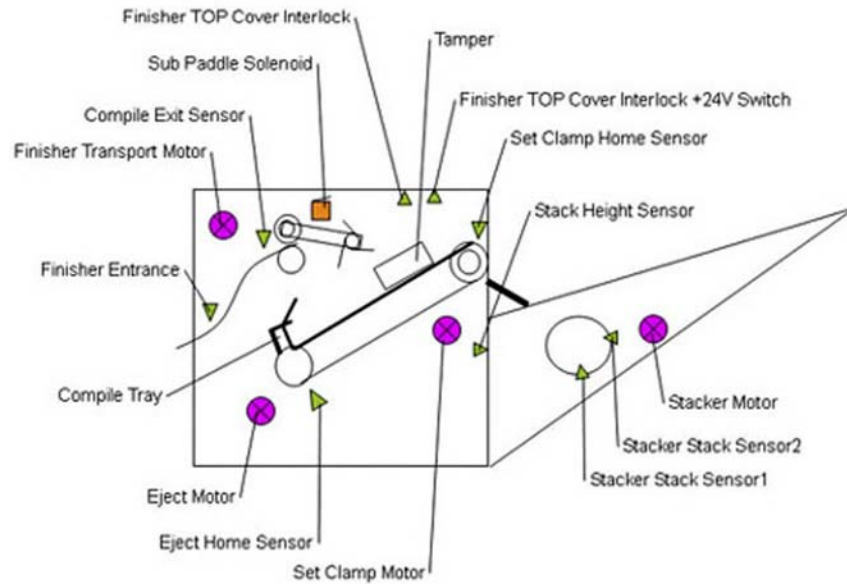
Figure 1 Components overview

The Integrated Office Finisher transports prints from the IOT to the compile tray where they are compiled and tamped into sets. The sets then are stapled and or offset (as specified) and delivered to the stack tray.

As the paper is transported past multiple sensors, signals are sent to the finisher PWB control logic that regulate various motors and solenoids used in the Integrated Office Finisher. Refer to [Figure 1](#).

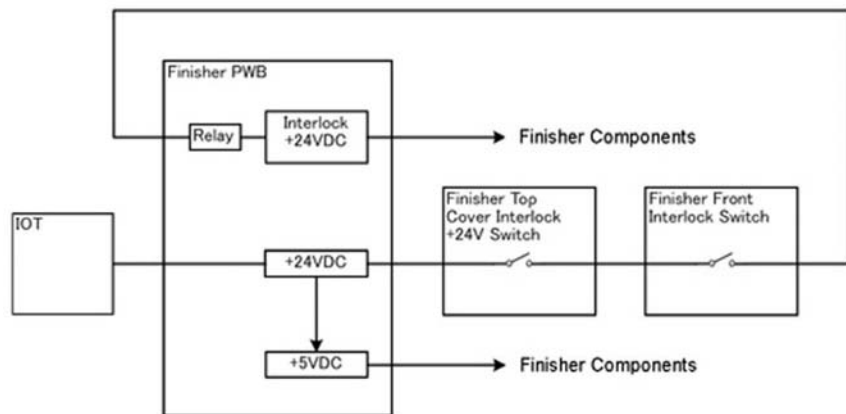
Figure 3 Power, control and interlocks

+24VDC output from the IOT is supplied to the finisher PWB. The finisher PWB generates +5VDC from +24VDC and it supplies +5VDC to various finisher components. In addition, +24VDC from the finisher PWB goes through the finisher top cover Interlock +24V switch and the finisher front Interlock switch, then returns to a relay on the finisher. When these interlock switches are both ON, the relay is energized and +24VDC is supplied to various finisher components. Refer to [Figure 3](#).

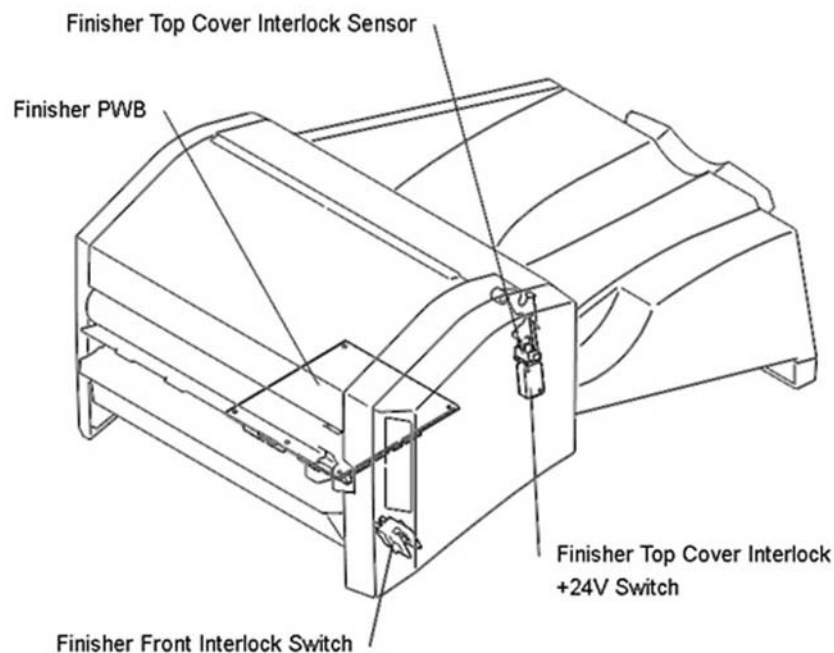
Figure 4 Power and control/interlocks

The finisher top cover interlock sensor is a +5VDC photo sensor that detects whether the top cover is open or closed. Refer to [Figure 4](#).

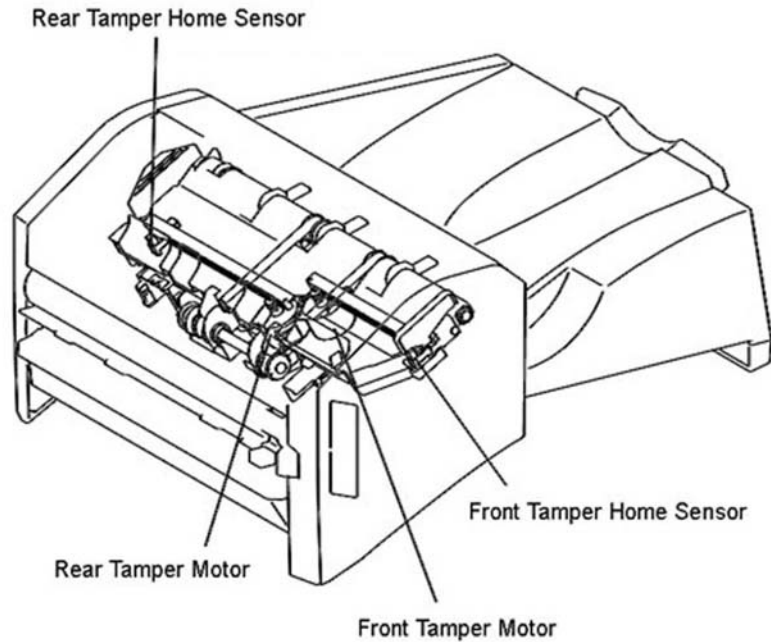
Figure 5 Tamper major components

Rear tamper motor - This stepper motor moves the rear tamper. When the motor rotates forward (CW), the rear tamper moves toward the rear of the compile tray.

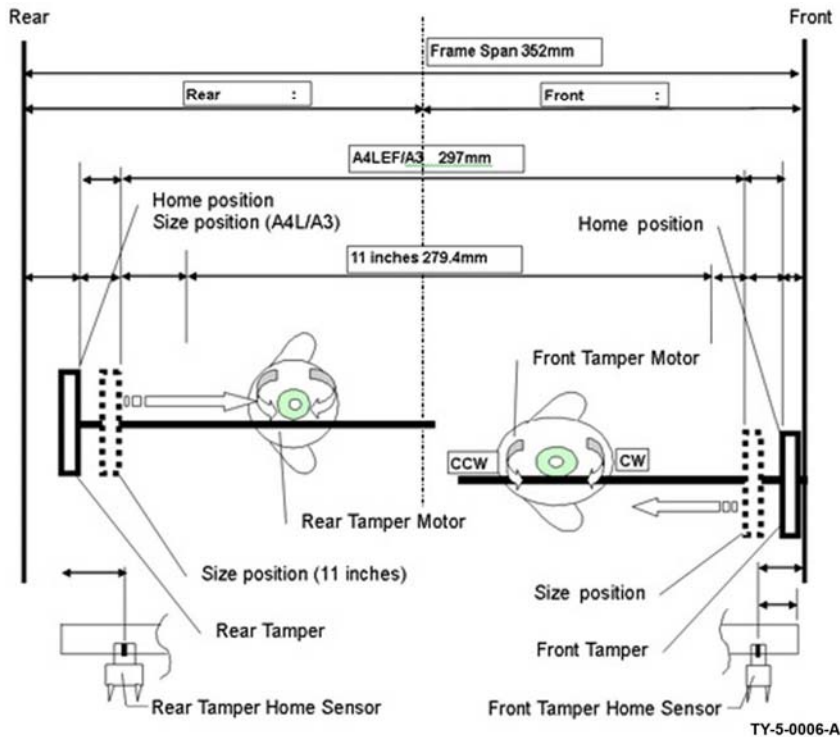
Figure 6 Tamper operation

During the tamping operation the tampers are moved, thereby aligning sheets of paper transported into the compile tray into a registered set. During the offset operation the paper sets are shifted, front and rear. The tampers also hold the paper set during the stapling operation.

Figure 6 shows the tamper positions when the width of the output paper is 182mm or more.

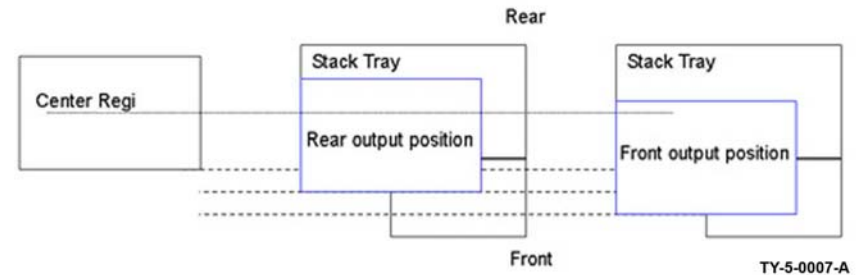
Figure 7 Tamping operation

After the output of the first set of paper, the front tamper moves to the rear offset position. When the second set of paper reaches the compile tray the tamping operation repeats. Refer to Figure 7.

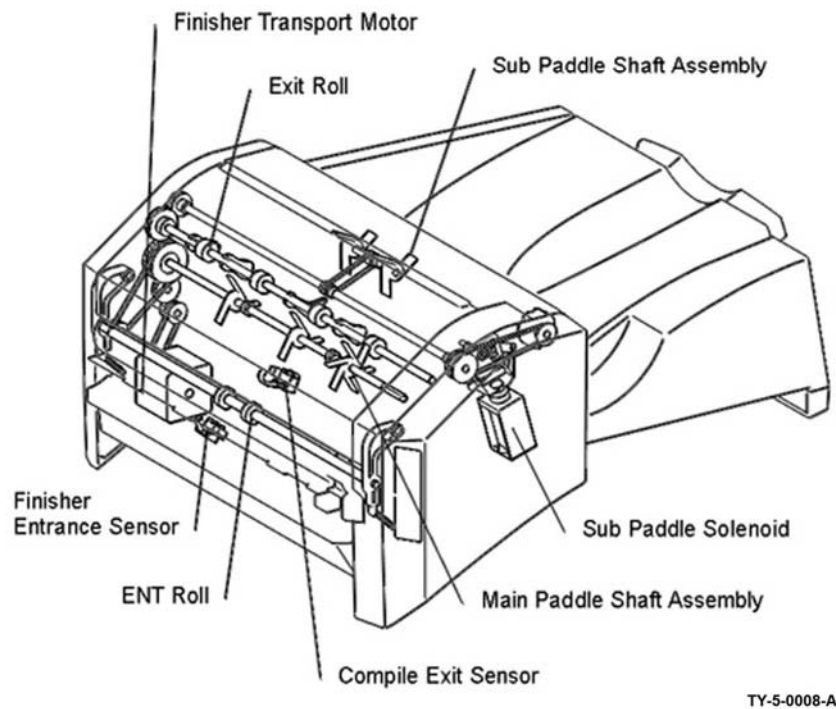
TY-5-0008-A

- **Finisher entrance sensor** - This photo sensor detects when the lead edge of paper has been transported to the finisher.
- **Finisher transport motor** - This stepper motor drives the ENT roll, Exit roll, main paddle shaft assembly, and the sub paddle shaft assembly.
- **Finisher transport motor** - This stepper motor drives the ENT roll, exit roll, main paddle shaft assembly, and the sub paddle shaft assembly.
- **Compile Exit Sensor** - This photo sensor detects when the lead edge of paper reaches the compile tray.
- **Sub Paddle Solenoid** - When the sub paddle solenoid is energized, the sub paddle shaft assembly moves downward.

Figure 8 Compiler components

The major components of the compiler are as follows, Refer to [Figure 8](#):

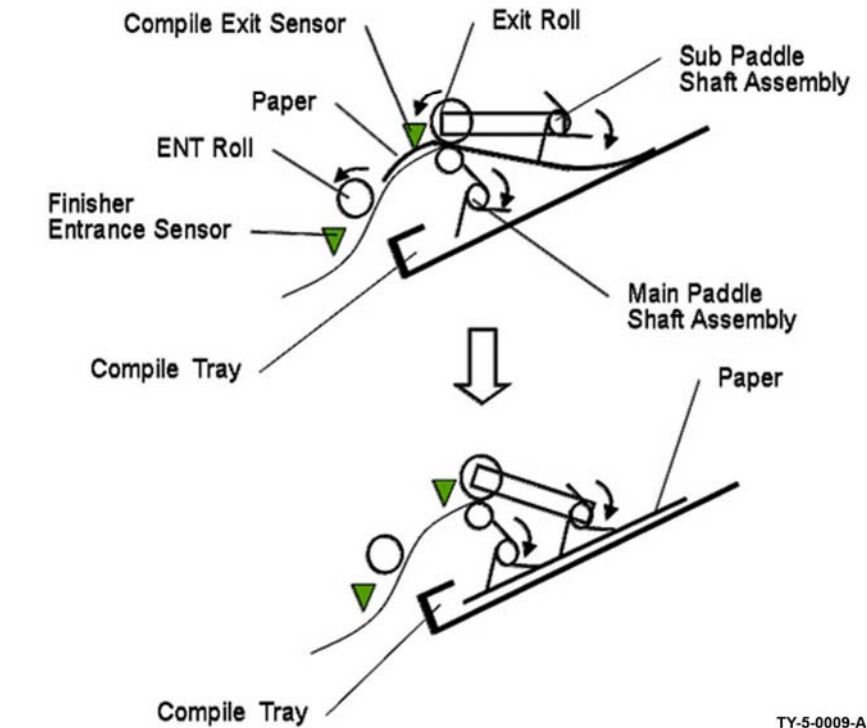
TY-5-0009-A

The ENT roll and exit roll rotate to transport paper from the IOT to the compile tray. At the same time, the paddles of the main paddle shaft assembly and sub paddle shaft assembly rotate to position the paper in the compile tray.

The paddles of the sub paddle shaft do not normally contact paper. At a specified time after paper passes the compile exit sensor, the sub paddle solenoid is turned ON and the sub paddle shaft assembly is lowered to contact the paper. Once the paper has been held in the compile tray, the sub paddle solenoid is turned OFF and the sub paddle shaft assembly is raised.

Figure 9 Compiler operation

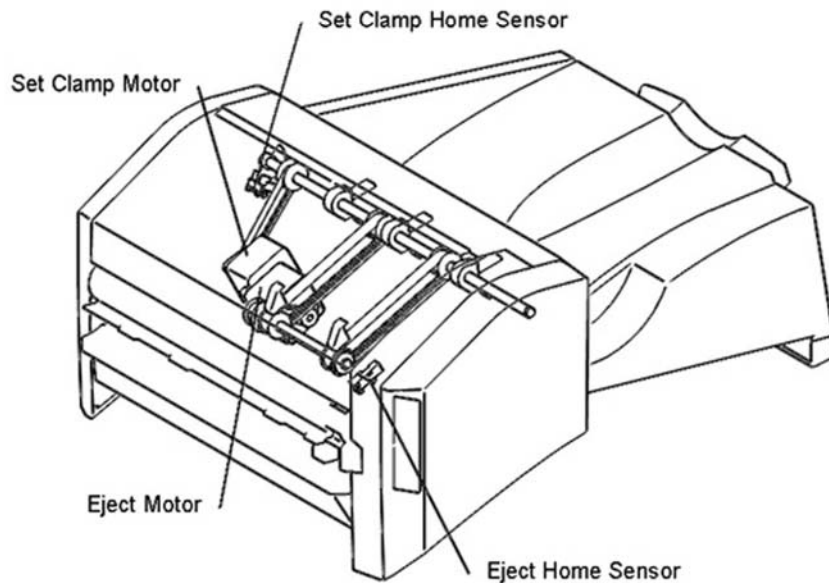
TY-5-0010-A

Eject Home Sensor - This photo sensor detects that the eject belt is in the home position. In the home position the belt guide is moved back. LOW (not blocked) = at home

Eject Motor - This stepper motor drives the eject belt in the forward (CW) direction to transport paper to the stack tray and rotates in reverse to move the eject belt to home.

Figure 10 Set ejection

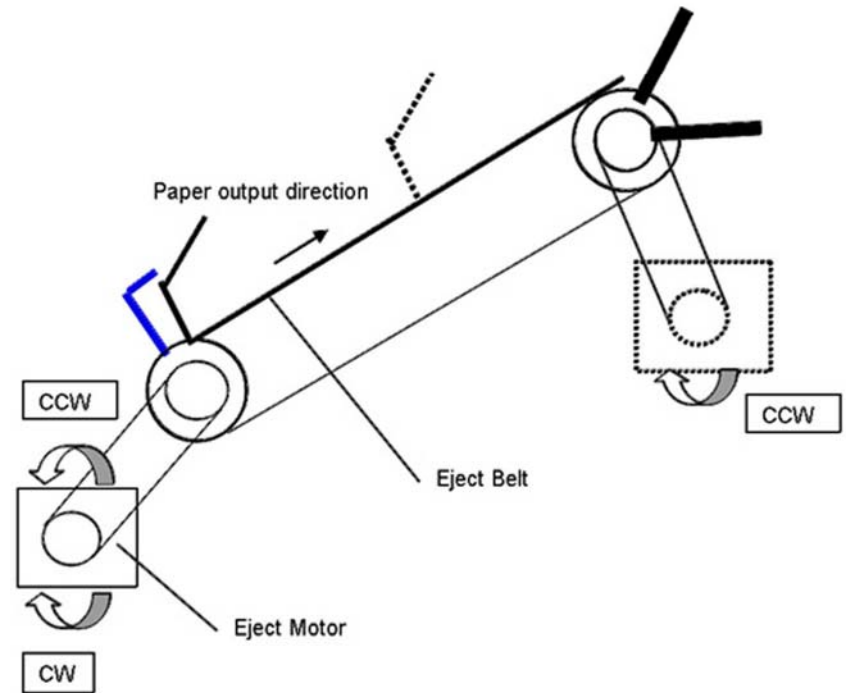
TY-5-0011-A

Once a specified number of sheets of paper have accumulated in the compile tray, the eject motor rotates forward (CW) for a specified time to drive the eject belts and output the set onto the stack tray.

Once the sets of paper have been output, the eject motor rotates in the reverse direction (CCW) to return the eject belts to the home position. Refer to [Figure 11](#).

Figure 11 Set ejection operation

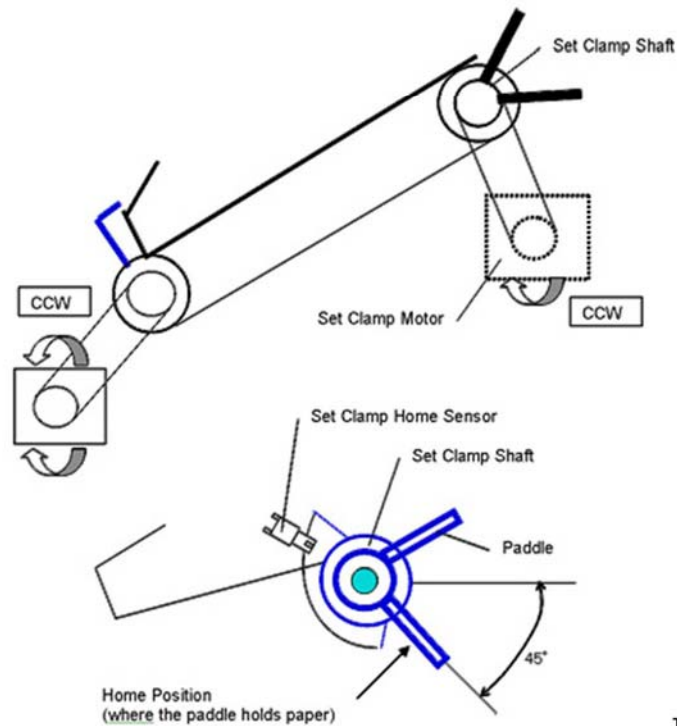
TY-5-0012-A

When the belt eject operation has output a set, the set clamp motor rotates in the reverse direction (CCW), which drives the set clamp shaft forward (CW). The paddles of the set clamp shaft rotate to register and hold the sheets of paper on the stack tray.

The home position of the set clamp shaft is such that the paddles hold paper. In this position the set clamp home sensor is not blocked. When the set clamp shaft is driven from its home position, the set clamp home sensor is blocked and the shaft will rotate until it returns to the home position. Refer to [Figure 12](#).

Figure 12 Set ejection operation detail

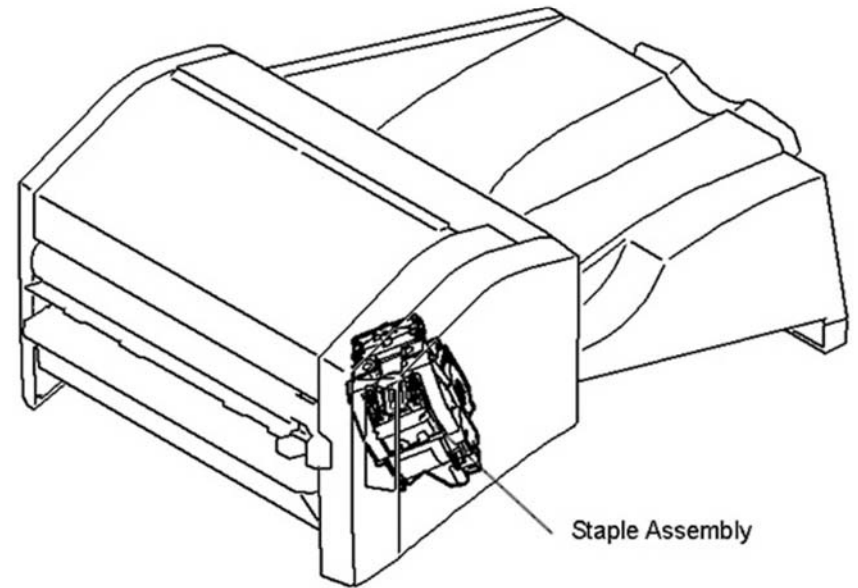
TY-5-0013-A

The staple assembly performs stapling. The staple motor in the staple assembly rotates in the forward direction (CW) to close the staple head, resulting in stapling, and then returns to the home position. If stapling fails, the staple motor reverses rotation (CCW) to near the home position. Refer to [Figure 13](#).

Staple assembly - The stapler unit consists of a staple head home sensor, staple motor, low staple sensor and staple ready sensor.

Figure 13 Stapler operation

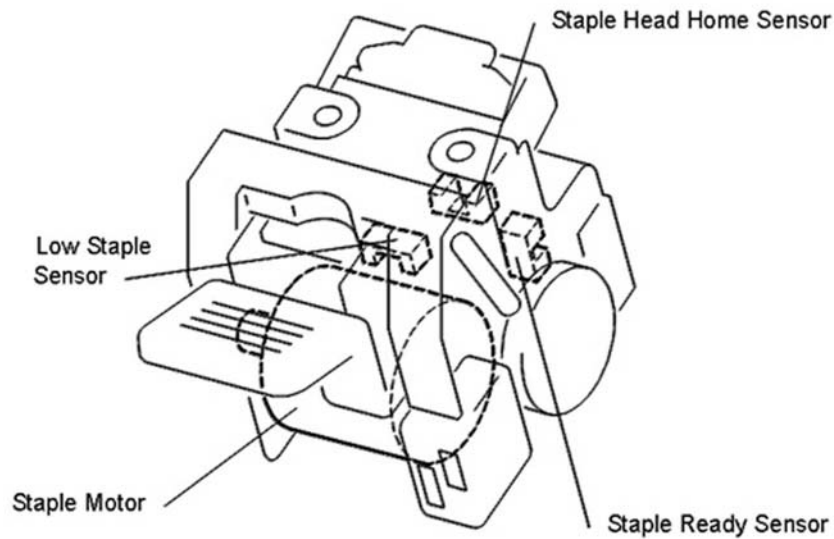
TY-5-0014-A

- **Staple Head Home Sensor** – The home sensor detects that the staple head is at the home position.
- **Staple Motor** - This DC motor drives the staple head.
- **Low Staple Sensor** - This photo sensor detects the presence of the staple cartridge and the quantity of staples that remain.
- **Staple Ready Sensor** - This photo sensor detects that a staple has reached the staple head.

Figure 14 Stapler major components

Refer to [Figure 14](#). The major Stapler components are:

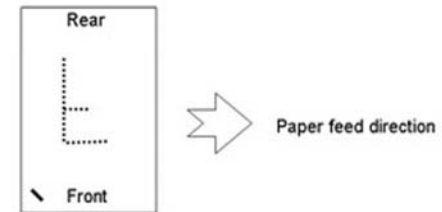
TY-5-0015-A

Stapling positions relative to a page placed in the document handler or placed on the platen glass are different for LEF paper and SEF paper, as shown. Refer to [Figure 15](#).

Paper supported	Portrait	Landscape
LEF	B5 A4 8.5 X 11 16 kai Executive		
SEF	A4 8.5 X 11 8.5 X 13 8.5 X 14 B4 A3 8 kai 11 X 17

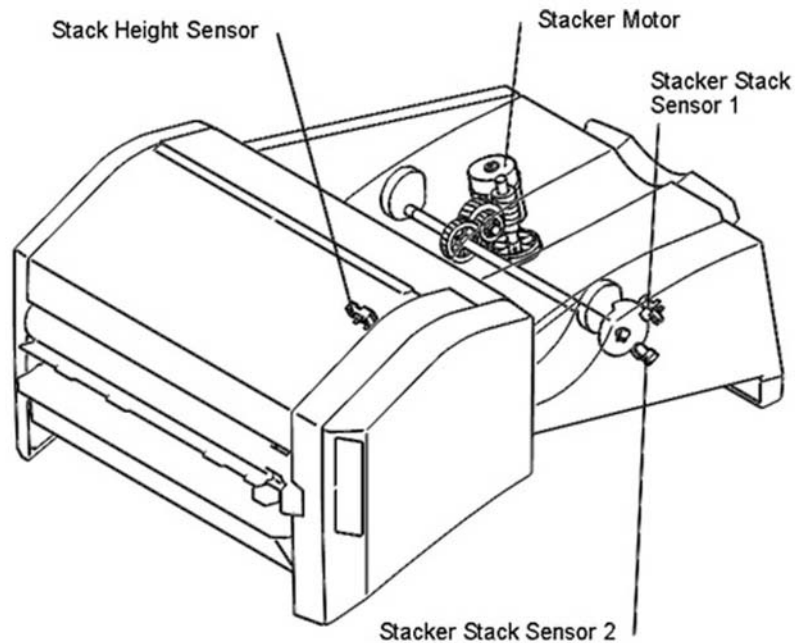
TY-5-0016-A

- **Stack Height Sensor** - This photo sensor (reflection type) detects the presence of paper in the stack tray. LOW (sensor receives light) = The reflective sensor detects paper present.
- **Stacker Stack Sensor 1 and 2** - These photo sensors in combination detect the position of the stack tray.
- **Stacker Motor** - This DC motor moves the stack tray up and down. The stacker motor rotates in the forward (CW) direction to drive the stack tray down. In the reverse rotation (CCW), the stack tray is driven up.

Figure 16 Stacker tray components

Refer to [Figure 16](#). The major components of the stacker tray are:

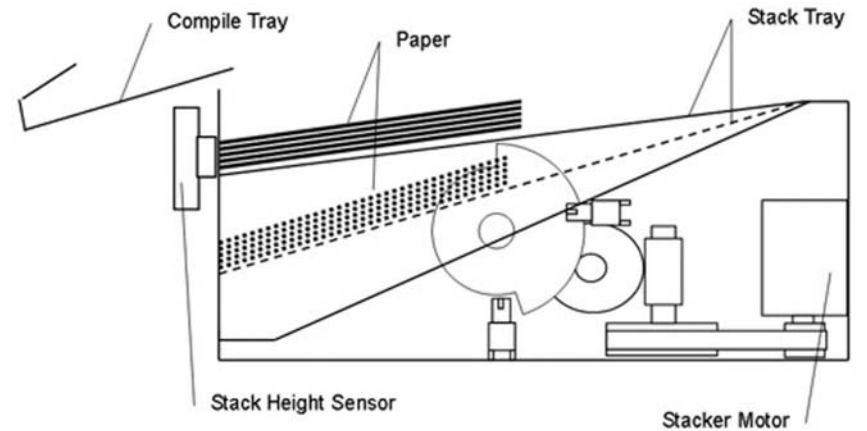
TY-5-0017-A

At the beginning of a job, when the tray is empty, the stack height sensor is not blocked and the stacker motor will raise the stacker tray to the uppermost position. The stack tray gradually goes down as more sheets of paper accumulate, up to a maximum number of sheets.

The stack height sensor detects paper at a specified time after they are output from the compile tray. When paper is detected, the stacker motor rotates forward (CW) to drive the stack tray down a specified distance. If the stack height sensor does not detect paper, the stack tray stays at the height it is at and waits for a next set to be output. Refer to [Figure 17](#).

Figure 17 Stack tray height adjustment

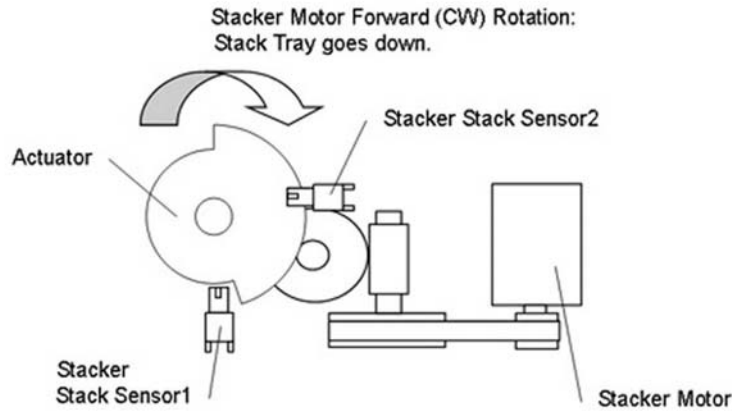
TY-5-0018-A

A stack tray without paper in it is positioned at the top of its travel range. Stack sensor 1 is unblocked while stack sensor 2 is blocked by the actuator on the stacker motor drive shaft. When sheets of paper accumulate, the stack tray will go down and both sensors will become blocked by the actuator. As more sheets of paper accumulate in the stack tray and the tray is driven down, stack sensor 2 and then stack sensor 1 will both become unblocked by the actuator (stacker tray full). Refer to [Figure 18](#).

Figure 18 Amount of Paper in Tray

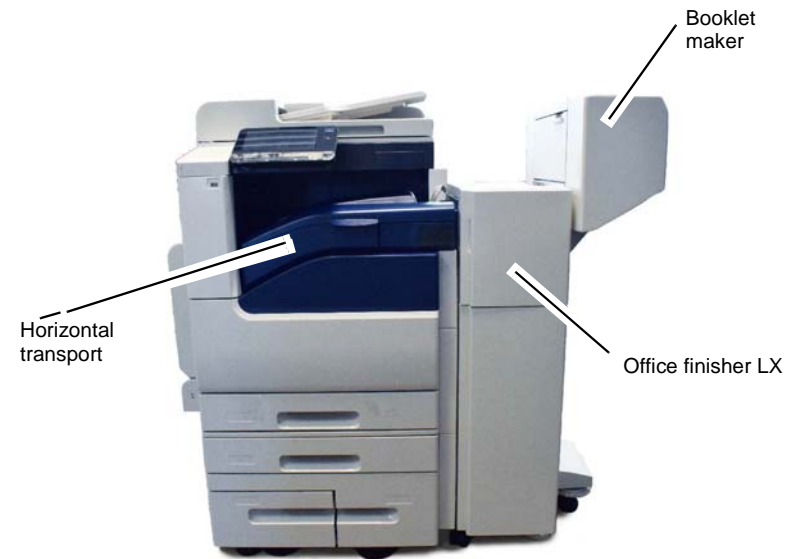
The finisher LX can collate, stack, staple, and hole punch up to 2000 sheets or 200 sets of 90gsm or 20lb paper. For paper sizes greater than A4 SEF, the maximum number of sets is limited to 100. Refer to [Figure 1](#).

Figure 1 Overview

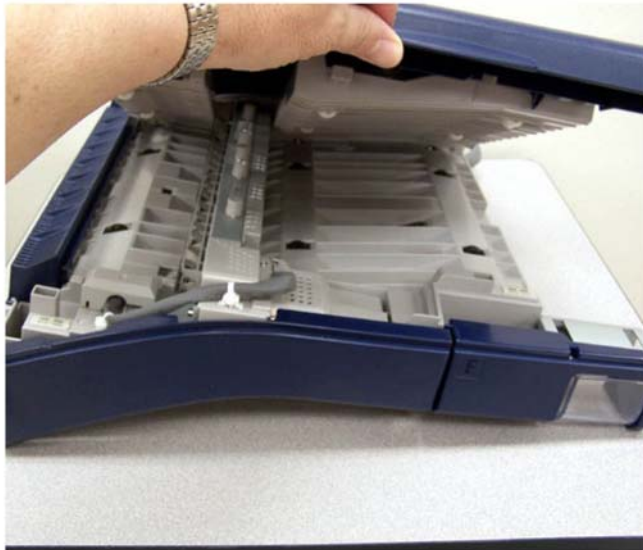
Y-5-0022-A

The top cover can be opened for jam clearance. Refer to [Figure 4](#).

Figure 4 Horizontal transport assembly

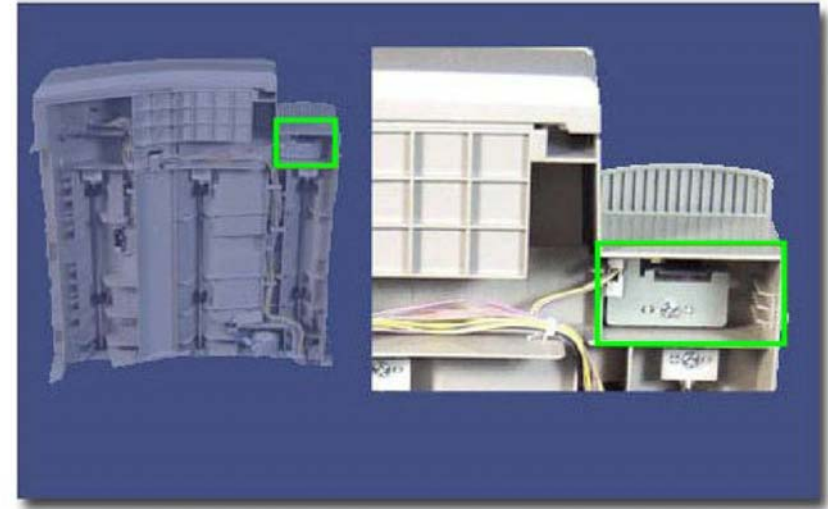
Y-5-0023-A

The H-transport open sensor can be viewed from the underside of the horizontal transport. Refer to [Figure 5](#).

Figure 5 Horizontal transport open sensor

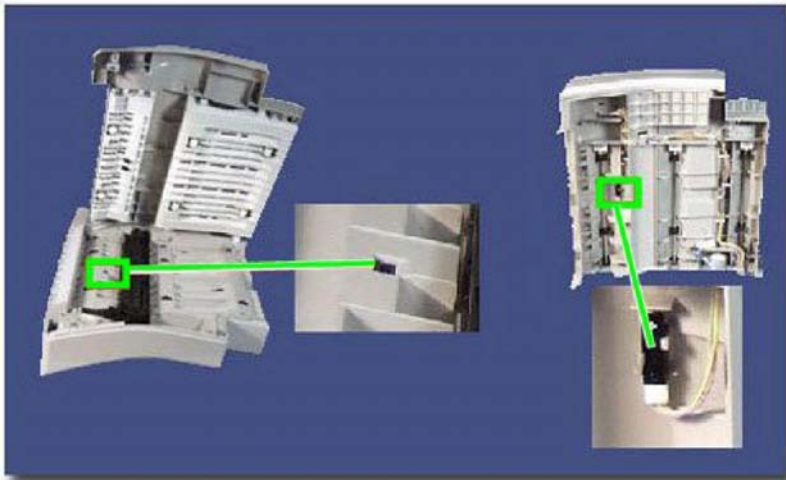
Y-5-0024-A

If, after a preset amount of time, the entrance sensor does not de-actuate, this indicates a paper jam and an error message is displayed on the UI. Refer to [Figure 6](#).

Figure 6 Entrance sensor

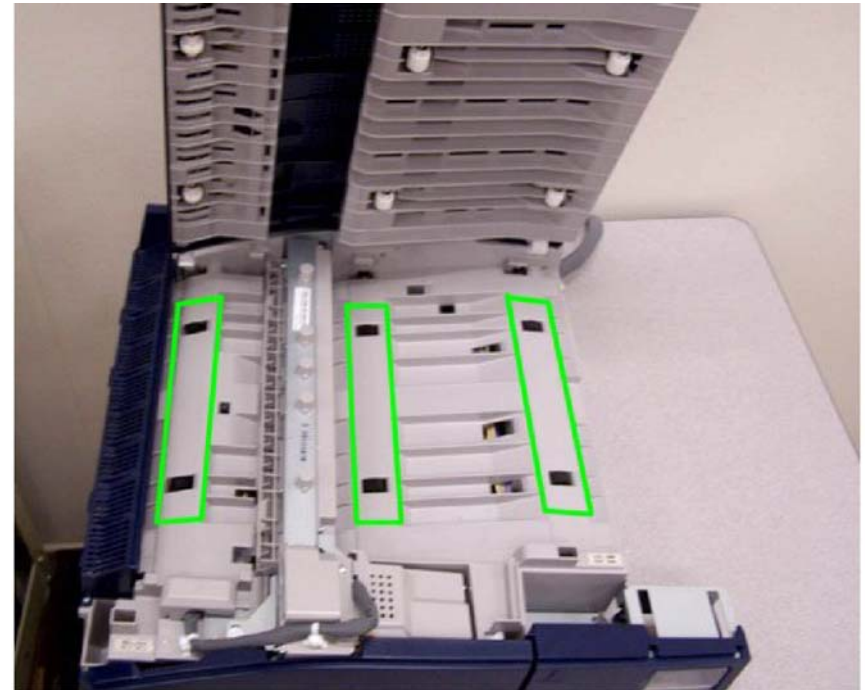
Y-5-0025-A

The paper is moved through the horizontal transport assembly by three sets of transport rolls.

Drive is provided to the transport rolls by the transport motor through a system of gears and belts. Refer to [Figure 7](#).

Figure 7 Transport rolls

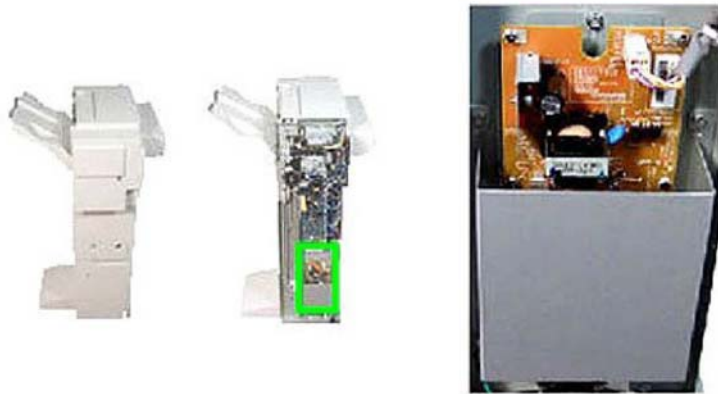
Y-5-0026-A

Power is supplied to the finisher components by the low voltage power supply (LVPS).

The LVPS receives 110/240VAC supply from the GFI via the power cord and provides +24V to the finisher PWB. Refer to [Figure 8](#).

Figure 8 Low voltage power supply

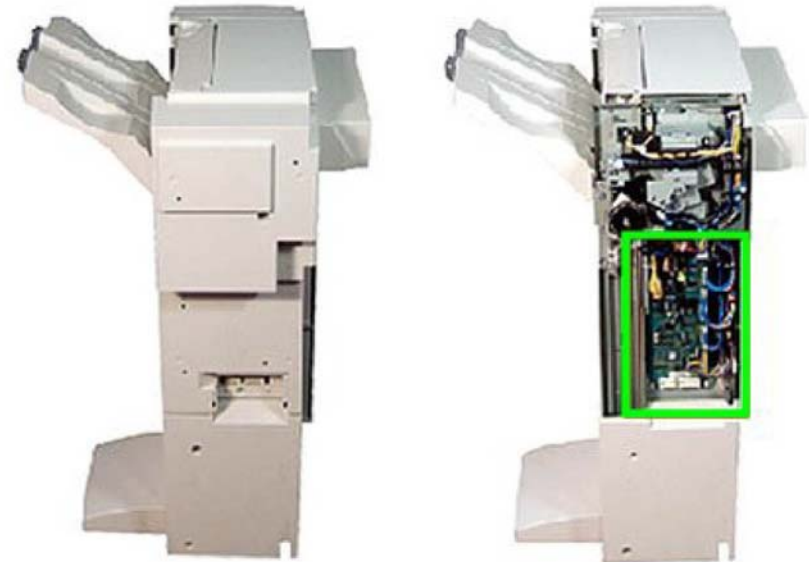
Y-5-0027-A

The finisher PWB receives +24V from the LVPS, which in turn it supplies to the motors and clutches.

In addition to the +24V supplies, the finisher PWB also provides +5V supply for all the sensors and switches. Refer to [Figure 9](#).

Figure 9 Finisher PWB

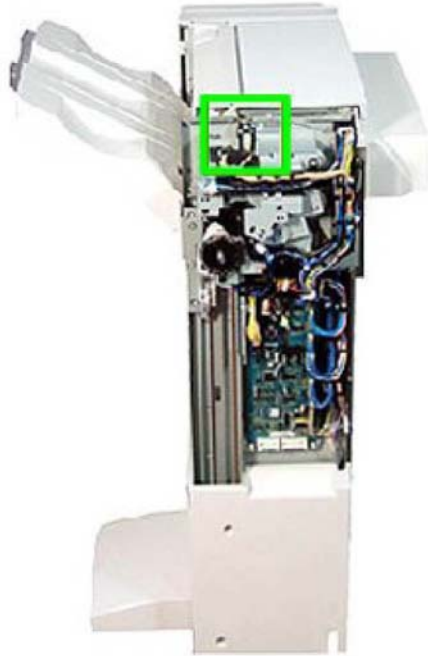
- **Eject Cover Switch** - triggered when the eject cover is raised. Refer to [Figure 10](#).
- **Front Door Interlock** - triggered when the front cover is opened. Refer to [Figure 11](#).

Figure 10 Eject cover switch

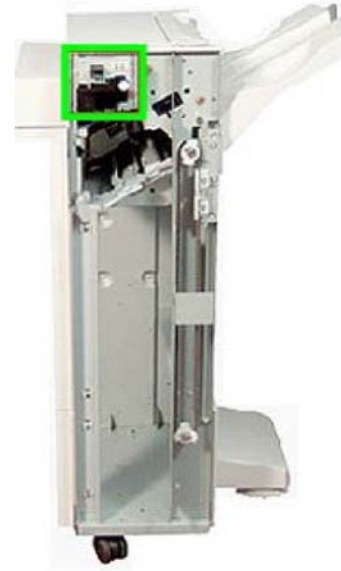
Figure 11 Front door interlock

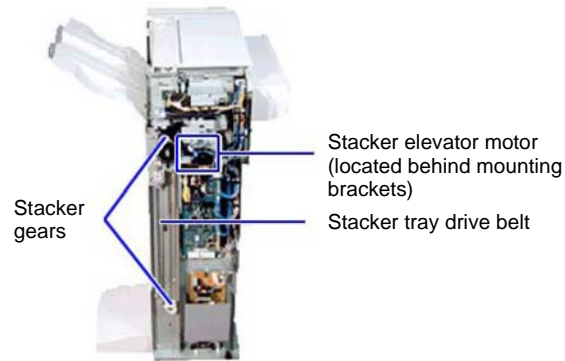
The stacker tray is an output tray on the finisher LX that is used to store compiled sets in a stack. The stacker tray lowers in steps to accommodate up to 200 sets.

The stacker tray is raised and lowered by a system of gears and belts. The gears and belts are driven by the stacker elevator motor through a rack gear. Refer to [Figure 12](#).

Figure 12 Stacker tray

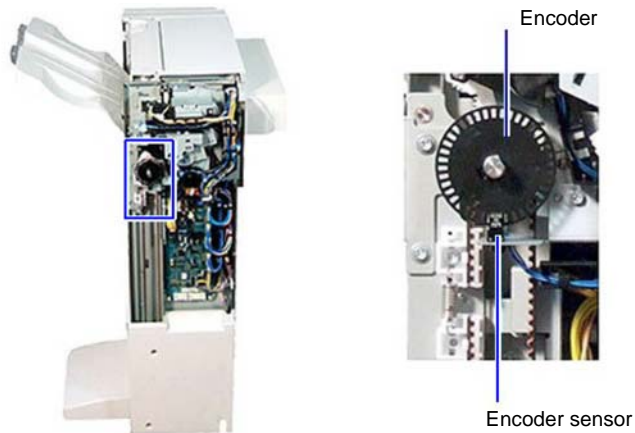
The encoder has a number of apertures cut into it and is connected directly to the main stacker tray drive gear via a shaft.

As the stacker tray drive gear rotates to lower or raise the stacker tray, the encoder also rotates. The rotation of the encoder is monitored by the encoder wheel sensor which is an optical sensor that reflects light onto the encoder. Refer to [Figure 13](#).

Figure 13 Encoder and sensor

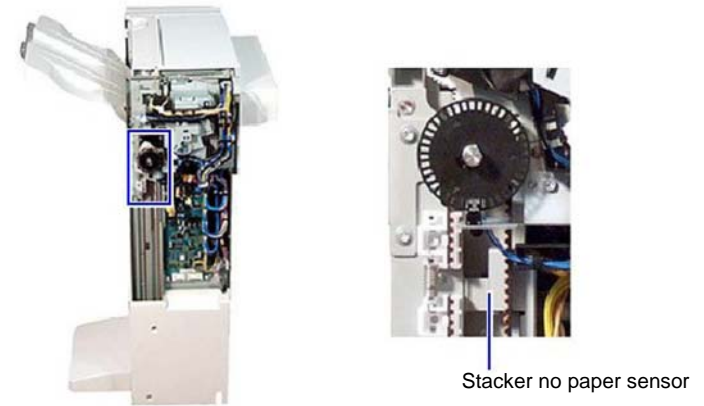
Y-5-0032-A

The uppermost position of the stacker tray is monitored by the stacker no paper sensor. When actuated, this indicates that the stacker tray is in the uppermost feed position. Refer to [Figure 14](#).

Figure 14 Stacker no paper sensor

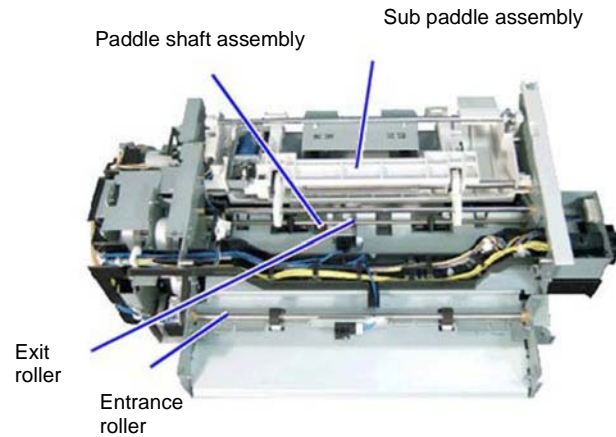
The sheets of paper are moved through the main section of the compiler by the entrance roll, exit roll, paddle shaft assembly and sub-paddle assembly.

Drive is provided to these components by the transport motor and a system of gears and pulleys. Refer to [Figure 15](#) and [Figure 16](#).

Figure 15 Compiler components

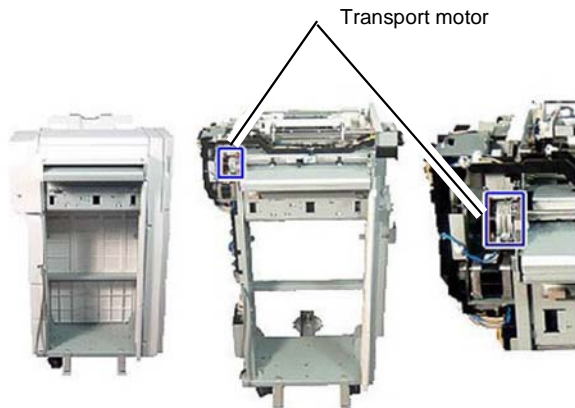
Figure 16 Transport motor

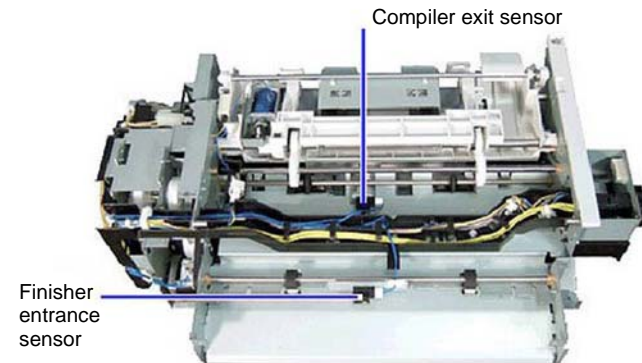
Y-5-0035-A

The entrance sensor is actuated by the lead edge of the paper entering the finisher from the horizontal transport. This signals the paper feed process to begin.

The compiler exit sensor is used to ensure that paper successfully moves through the paper path. If the compiler exit sensor is not actuated within a pre-set time of the entrance sensor being actuated, a paper jam condition is signalled and an error message appears. Refer to [Figure 17](#).

Figure 17 Entrance sensor and compiler exit sensor

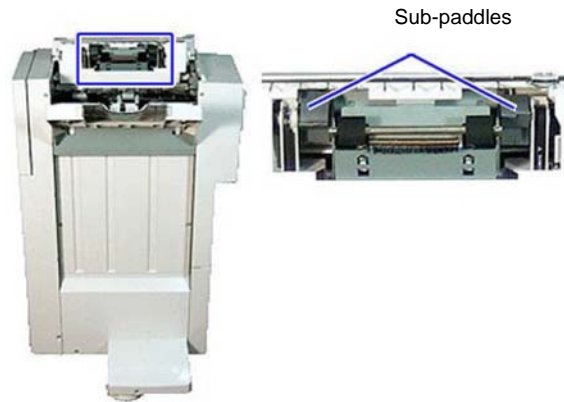
Y-5-0036-A

The sub-paddle assembly actively drives fed paper into the compiler tray when it exits the exit roll.

The sub-paddle assembly consists of a set of sub-paddles, an eject chute, and a solenoid. drive is provided by the transport motor. Refer to [Figure 18](#).

Figure 18 Sub paddle assembly

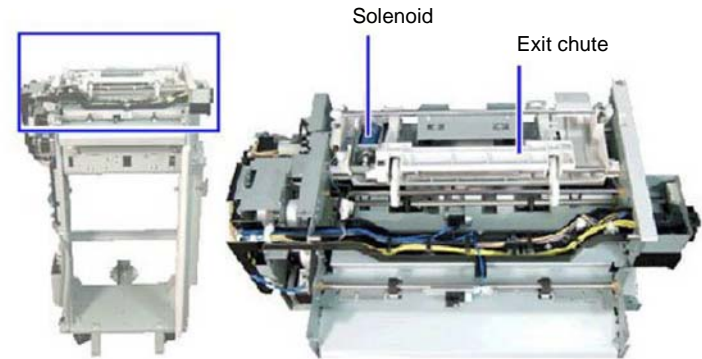
Y-5-0037-A

The rotation of the sub paddles actively drives the paper against the compiler backstops where the paper is tamped, stapled (if required), and ejected.

The sub paddles rotate constantly and only come into contact with the paper when the solenoid is actuated. Refer to [Figure 19](#), [Figure 20](#) and [Figure 21](#).

Figure 19 Exit chute

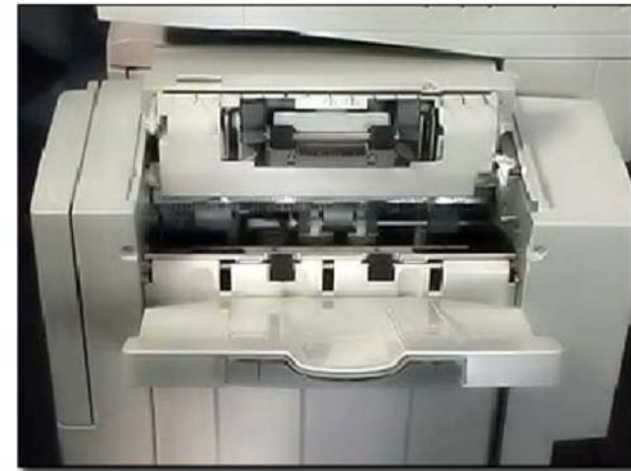
Y-5-0038-A

Figure 20 Sub paddle assembly

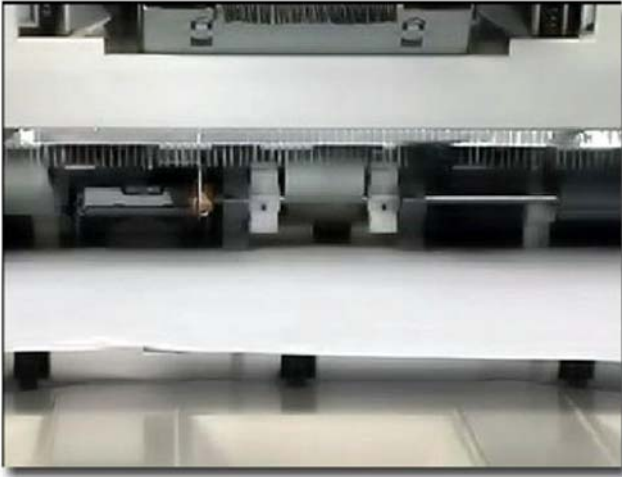
Y-5-0039-A

Figure 21 Closer view

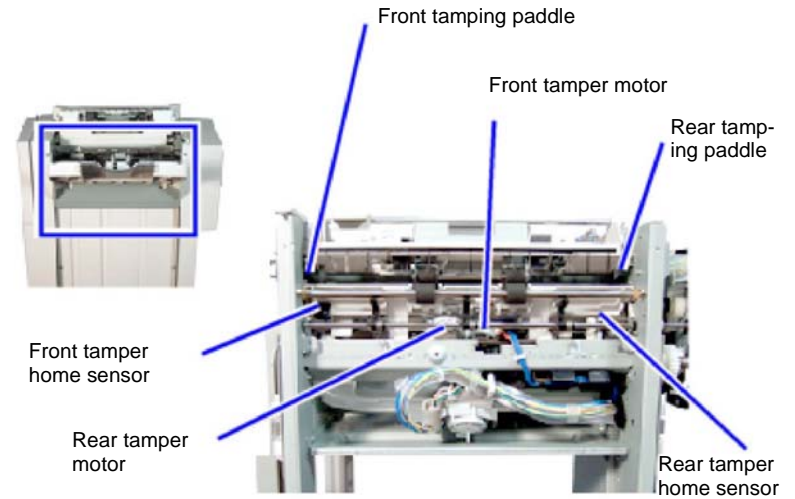
Y-5-0040-A

The tamper assemblies are used to compile sets of paper into registered stacks either for stapling or exit to the stacker tray. The tamper assemblies tamp the sets of paper to the front, center, or rear of the compiler, as required.

The Finisher LX has two separate tamper assemblies which operate as a single unit. These are the front and rear tamper assemblies. Each tamper assembly consists of a tamping paddle, tamper paddle motor, and a tamper home sensor. Refer to [Figure 22](#).

Figure 22 Tamper assemblies

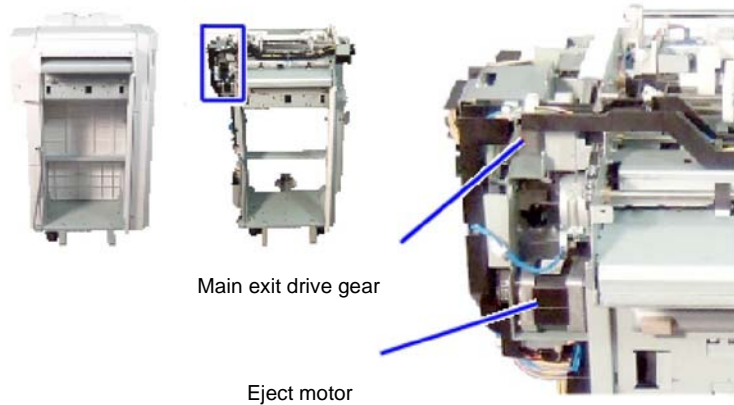
Y-5-0041-A

The exit roll, paper guides, and set clamp assembly all are driven by the eject motor through the main exit drive gear.

Each assembly has a discrete system of gears and quadrant gears which transfer drive from the main exit drive gear to the individual assembly. Refer to [Figure 23](#).

Figure 23 Main exit drive

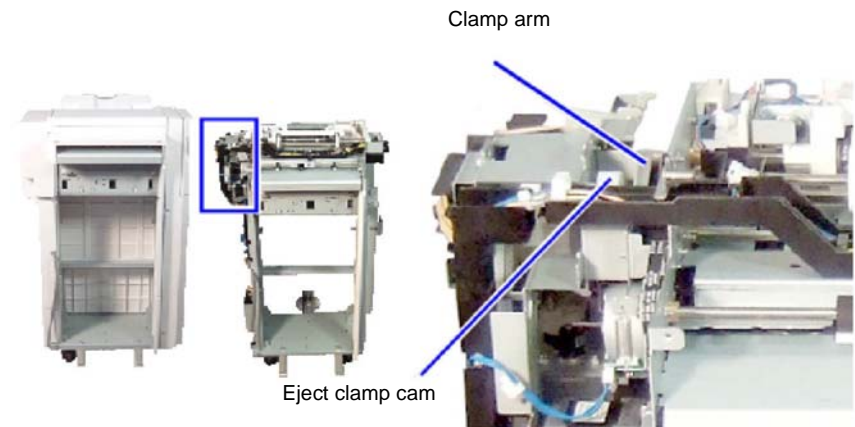
Y-5-0042-A

The exit cam roll, driven by the main exit drive gear, moves the retaining chassis into the raised or lowered position by actuating the retaining chassis lever.

The lower exit roll is driven by the exit roll gears through the main exit drive gear. Paper is moved from the compiler tray to the stacker tray when the upper exit roll is lowered onto the lower exit roll. Refer to [Figure 24](#).

Figure 24 Exit clamp

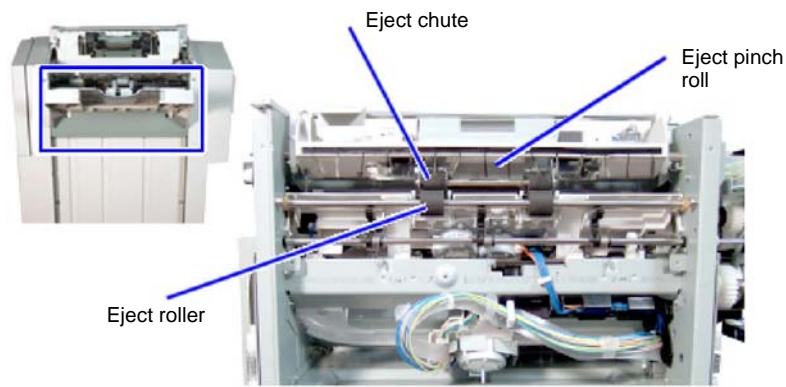
Y-5-0043-A

The eject roll is driven by the exit roll gears through the main exit drive gear.

Paper is moved from the compiler tray to the stacker tray when the eject pinch roll is lowered onto the eject roll. Refer to [Figure 25](#).

Figure 25 Exit roll assembly

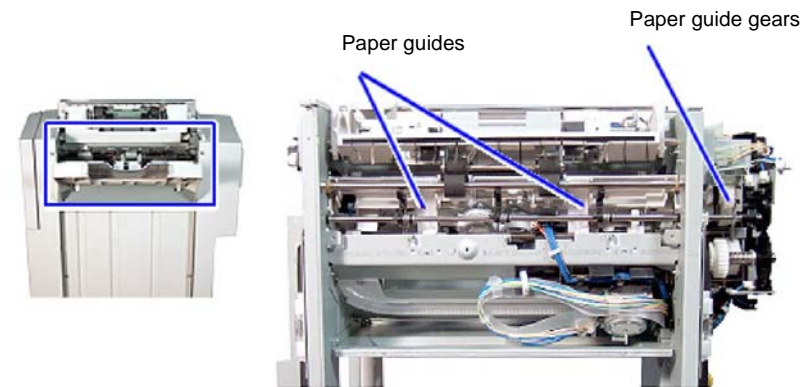
Figure 26 Paper guide

As the main exit drive gear rotates, the eject assembly also rotates, thereby extending or retracting the paper guide.

This action is reversed by a change in direction of the main exit drive gear. Refer to [Figure 26](#).

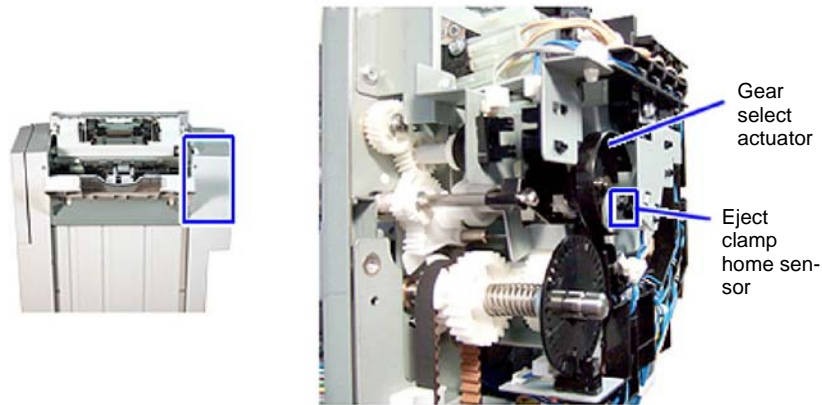
Figure 27 Eject assembly

The gear select actuator is fixed to the end of one of the drive shafts for the eject assembly and rotates to trigger the eject clamp home sensor.

The eject clamp home sensor and gear select actuator are only used to confirm that the support arms are fully extended or retracted. They do not control drive to the main exit drive gear. Refer to [Figure 27](#).

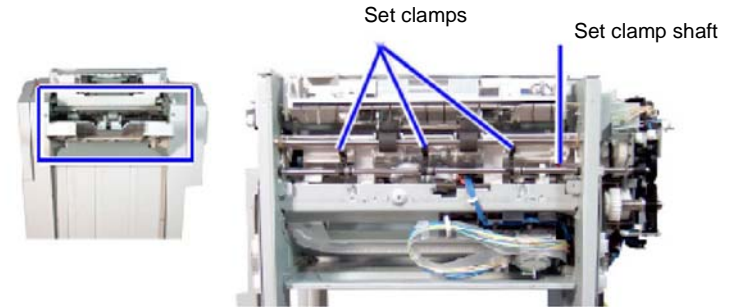
Figure 28 Set clamps

The set clamp assembly uses set clamps to hold sets of paper in position on the stacker tray. The set clamps are fixed to the set clamp shaft which is rotated by the set clamp quadrant gear. Drive is provided by the main exit drive gear. Refer to [Figure 28](#).

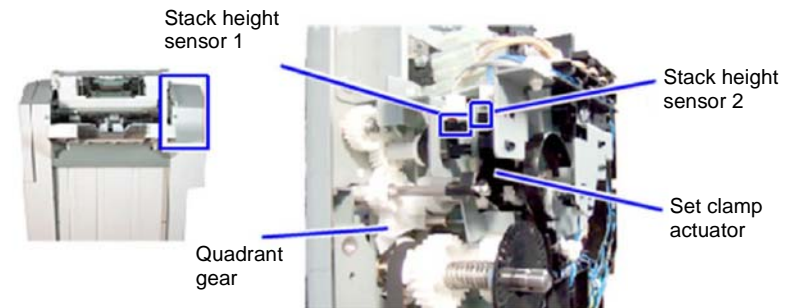
Figure 29 Set clamp position

The position of the set clamp is monitored by two sensors. These are the upper and lower stack height sensors. The set clamp actuator is fixed to the end of the paper clamp shaft and triggers the sensors when the set clamps are in either the upper or lower position. The sensors and actuator are only used to confirm that the set clamps are fully raised or lowered. They do not control drive to the main exit drive gear. Refer to [Figure 29](#).

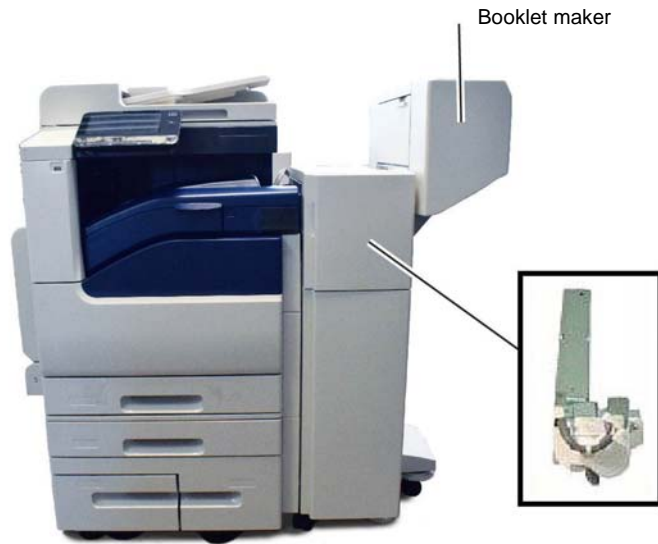
Figure 30 Booklet maker

The optional booklet maker produces pre-creased booklets with either 1 or 2 staples. The booklet maker is supplied with a crease assembly which is installed into the Finisher LX. Refer to [Figure 30](#).

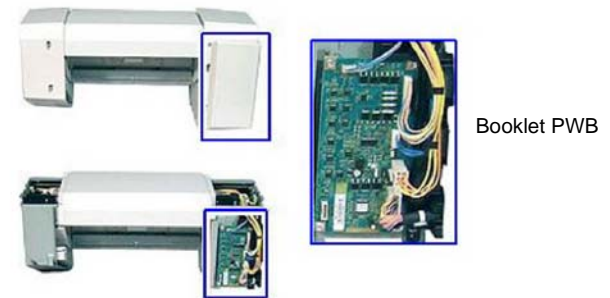
Figure 31 Booklet maker power and control

The booklet PWB controls all the booklet maker components and distributes the +24V supply to the motors and +5V to the sensors and interlocks.

The crease assembly is powered and controlled by the finisher PWB. Refer to [Figure 31](#).
