708P91370
April 2017

Xerox® VersaLink® B7025/B7030/B7035 Multifunction Printer Service Manual

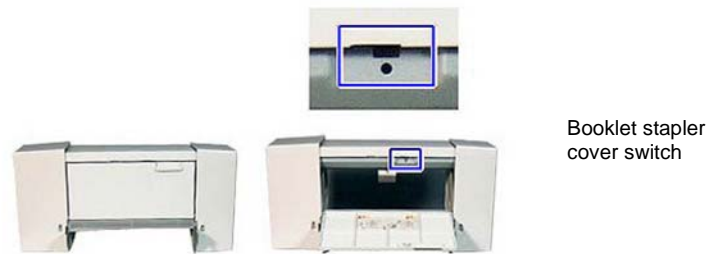
Figure 32 Booklet stapler cover switch

The booklet stapler cover switch is actuated when the side cover is opened. When actuated, all + 24V supplies are removed from the booklet maker. Refer to [Figure 32](#).

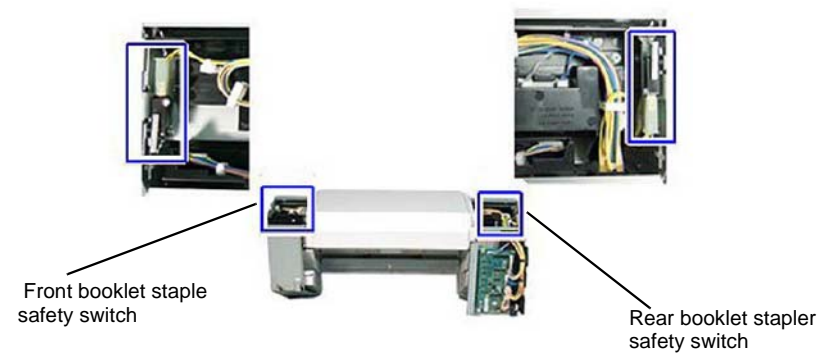
Figure 33 Front and rear safety switches

The front and rear booklet stapler safety switches are actuated when either the front or rear covers are raised.

These Interlocks prevent the booklet maker from operating when either the front or rear covers are obstructed, i.e., raised, or when the booklet maker is incorrectly mounted. Refer to [Figure 33](#).

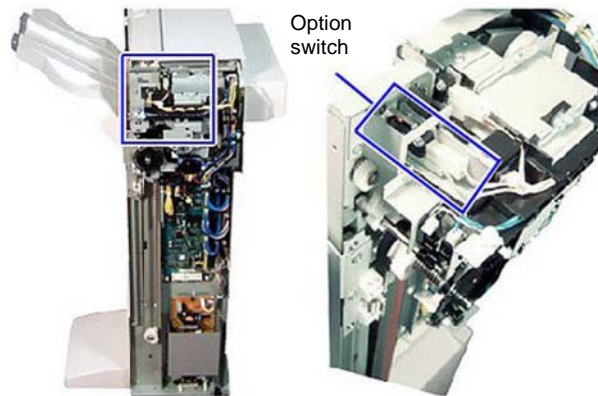
Figure 34 Finisher side interlock

An option switch is used to detect when the booklet maker is installed on the finisher. This Interlock is located on the Finisher LX, not the booklet maker.

When Interlocks are open, power is removed and an error message displays on the UI. Refer to [Figure 34](#).

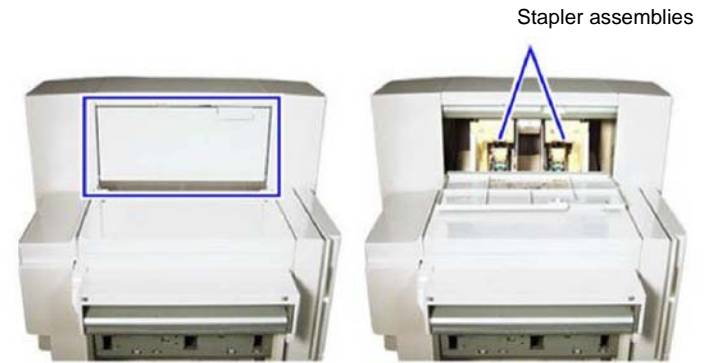
Figure 35 Stapler assemblies

The booklet maker contains two staple assemblies which support and staple compiled booklets prior to ejecting into the stacker tray.

Each staple assembly contains a staple module and an exit sub chute. The staple units are mounted on a carriage rail. Refer to [Figure 35](#).

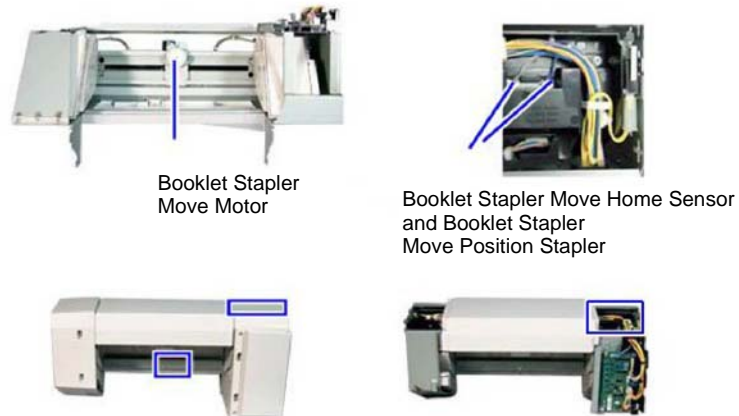
Figure 37 Stapler move motor

The booklet stapler move motor drives two rack gears, one connected to each stapler assembly.

The position of the stapler assemblies is controlled by the booklet stapler move home sensor and booklet stapler move position sensor which monitor the position of the rack gears. Refer to [Figure 38](#).

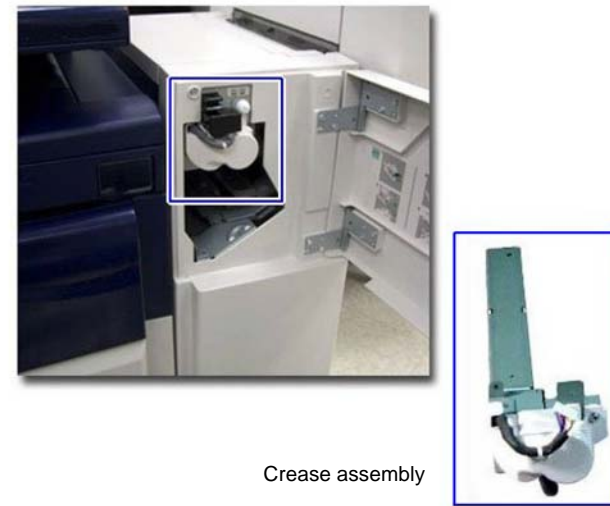
Figure 38 Crease assembly

It is installed behind the compiler within the Finisher LX and is controlled by the finisher PWB.

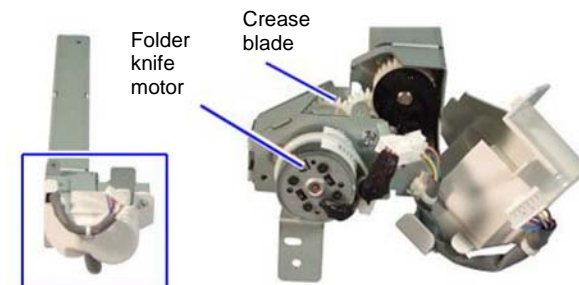
Figure 39 Crease assembly folder and gears

The crease assembly consists of a folder knife motor, gears, crease blade and paper chute.

The folder knife motor raises and lowers the crease blade through one cycle of the gears. Refer to [Figure 39](#).

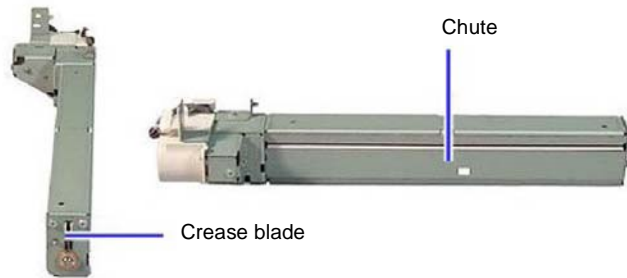
Figure 40 Crease blade and chute

The position of the paper within the crease assembly is monitored by the entrance and compiler exit sensors (part of the finisher LX).

When the paper is in the correct position within the paper chute, the paper momentarily stops feeding and the crease blade is raised and lowered. Paper feed now resumes. Refer to [Figure 40](#).

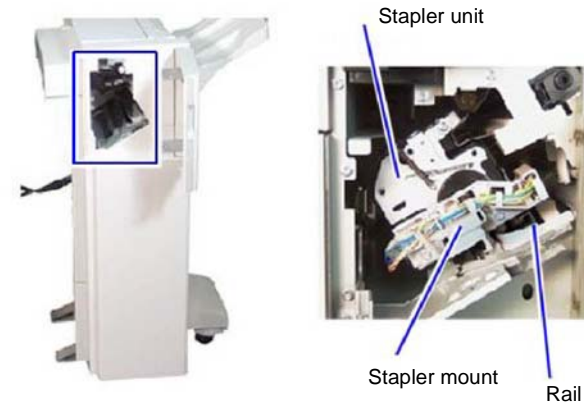
Figure 41 Stapler unit

The compiler stapler has a stapler unit which is installed on a stapler mount. The stapler mount moves the stapler unit to key stapling positions along the rail. Refer to [Figure 41](#).

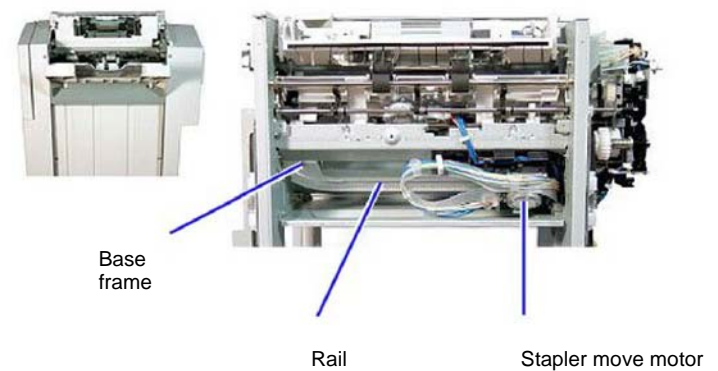
Figure 42 Stapler mount movement

The stapler mount is driven by the stapler move motor which is secured to the bottom of the stapler mount.

A gear fixed to the end of the stapler move motor drives the stapler mount along the rail, which is an integral part of the base frame. Refer to [Figure 42](#).

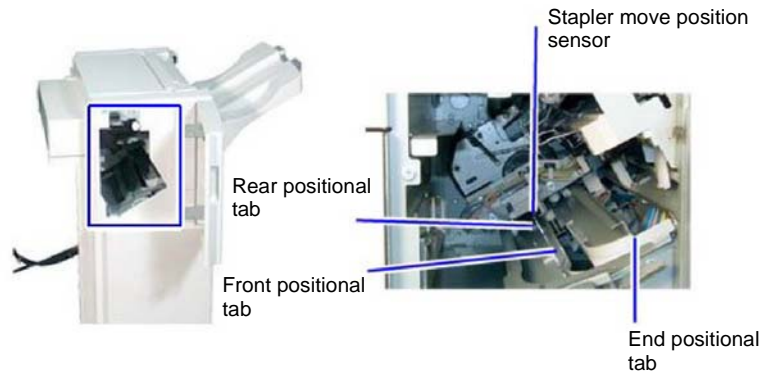
Figure 43 Stapler mount position

The end positional tab is used to indicate the correct position along the base frame for single stapling.

The front and rear positional tabs are used to indicate the correct position along the base frame for double stapling. Refer to [Figure 43](#).

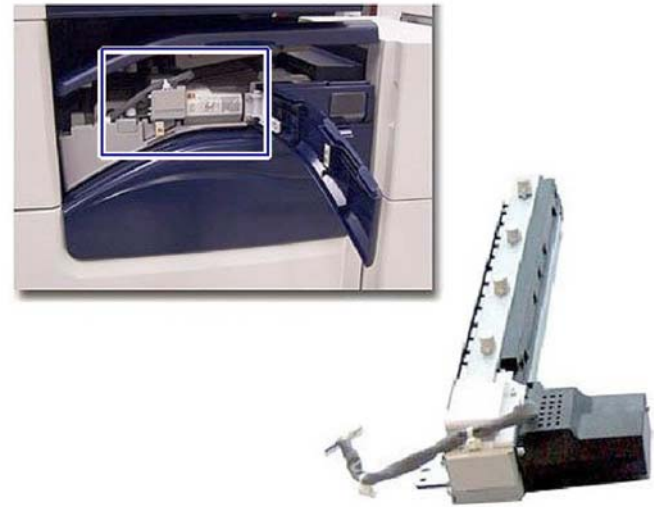
Figure 44 Hole punch assembly

The hole punch assembly punches either 2 or 4 holes in Europe or 2 or 3 holes in North America. The hole punch assembly is installed within the horizontal transport. It is controlled by the finisher PWB. Refer to [Figure 44](#).

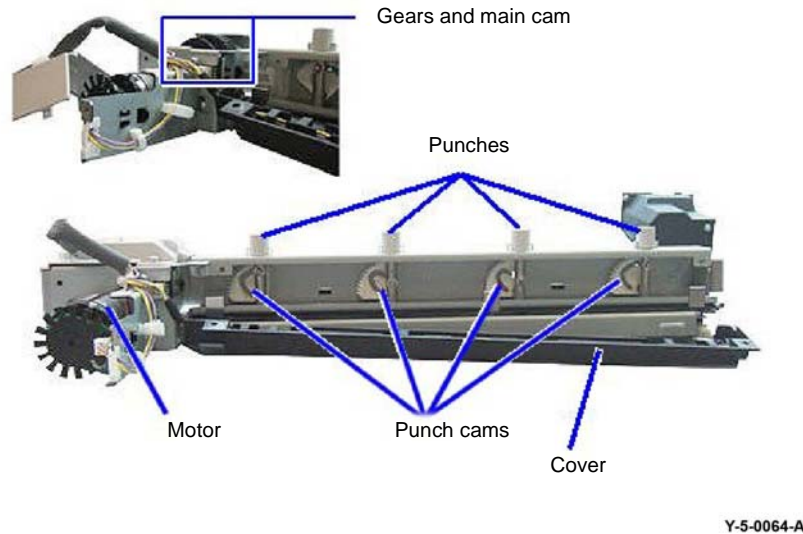
Figure 45 Hole punch components

The motor raises and lowers the punches through one cycle of the gears.

When the motor rotates in a clockwise direction it operates the two inner punch cams and in a counter-clockwise direction it operates all four (XE) or three (USSG, XCL) punch cams. Refer to [Figure 45](#).

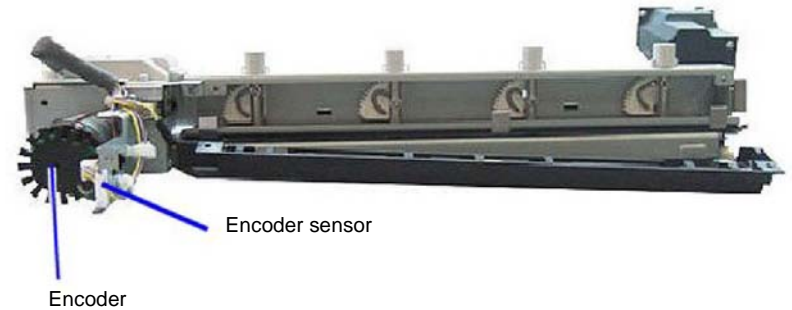
Figure 46 Hole punch encoder

The operation of the hole punch is controlled by an encoder and sensor. The encoder has a number of apertures cut into it and is connected to the motor. As the motor rotates the gears to operate the hole punch, the encoder also rotates.

The rotation of the encoder is monitored by the encoder sensor which is an optical sensor that reflects light onto the encoder. Refer to [Figure 46](#).

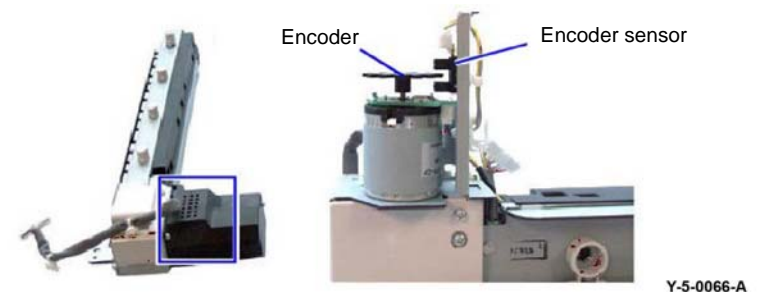
Figure 47 Encoder wheel and sensor

The rotation of the encoder wheel causes the apertures to pass through the encoder sensor wheel, allowing light to pass. This triggers the sensor, which indicates that the hole punch has rotated one cycle. Refer to [Figure 47](#).

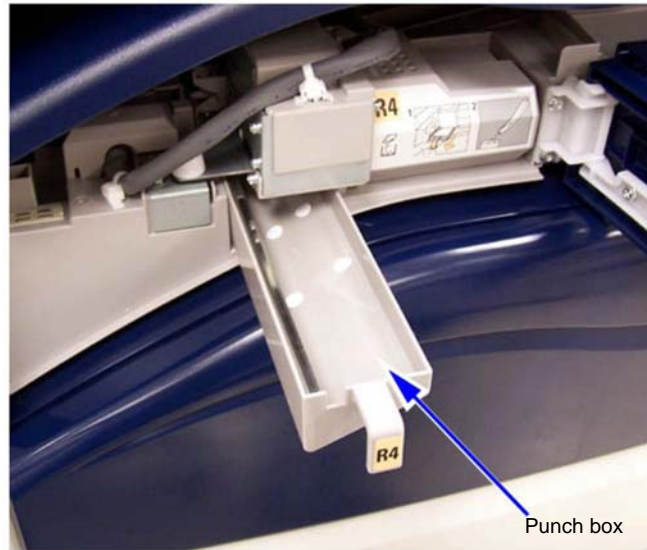
Figure 48 Hole punch box

The punch box is located beneath the hole punch assembly and collects the discarded chads. This will need to be emptied periodically. Refer to [Figure 48](#).

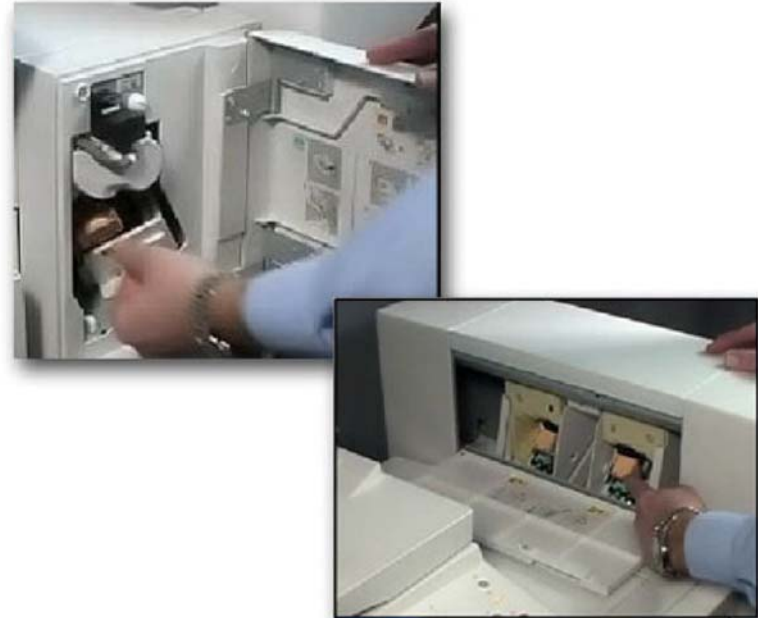
Figure 49 Customer replaceable units

Refer to [Figure 49](#). The only customer replaceable units (CRUs) for the LX finisher are:

- The 5,000 stitch staple cartridge and
- The two staple cassettes for the booklet maker. Each of the staple cassettes holds 2,000 staples.

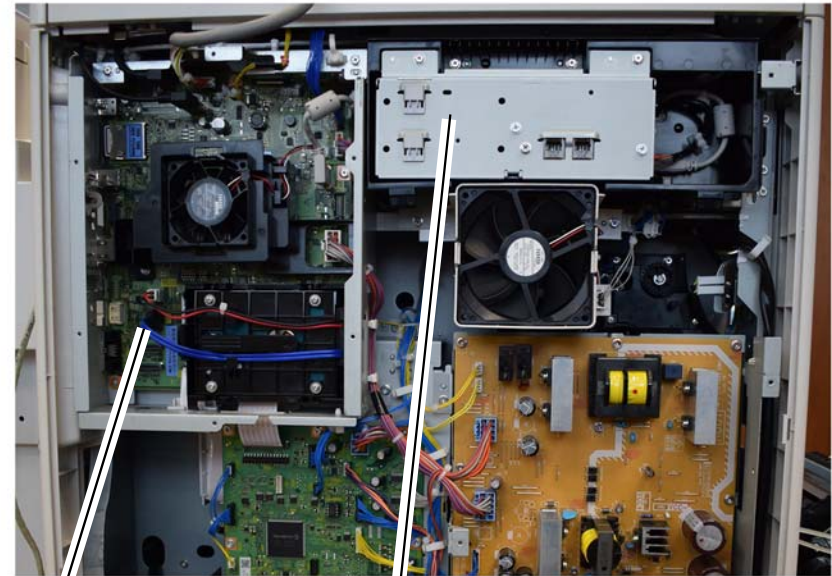
Fax over IP (VoIP Fax) is a purchasable option, installed via the USB port, which allows the printer to send and receive faxes over an IP based network using session Initiation Protocol (SIP) and Voice over IP (VoIP) protocols and services. The Fax over IP enabled printer can send and receive faxes from a variety of analog and digital devices.

ESS PWB

Fax module (1-line module shown)
