VersaLink® C500/C600 Printer and C505/C605 Multifunction Printer

Service Manual

Xerox VersaLink C605F Family Printer Service Manual

705P01395

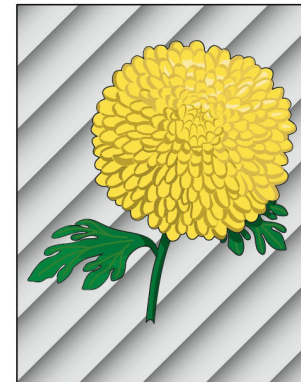
- Check that the paper is clean, dry, and meets specifications.
- Check CRU life counts. Replace components at end of life.
- Check if the printer contains Genuine Xerox Toner cartridges and parts.

Figure 1 Diagonal banding (auger marks) example

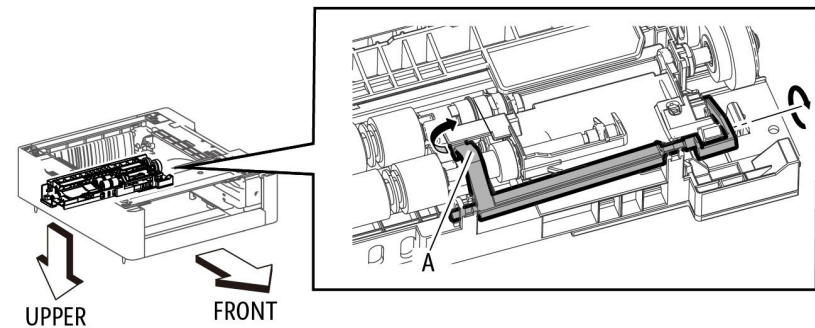
s6510_6515-047

4. Refer to [Figure 2](#) to release the portion A of the No Paper Actuator in the direction of the arrow and fully rotate the actuator.

Figure 2 Release the No Paper Actuator

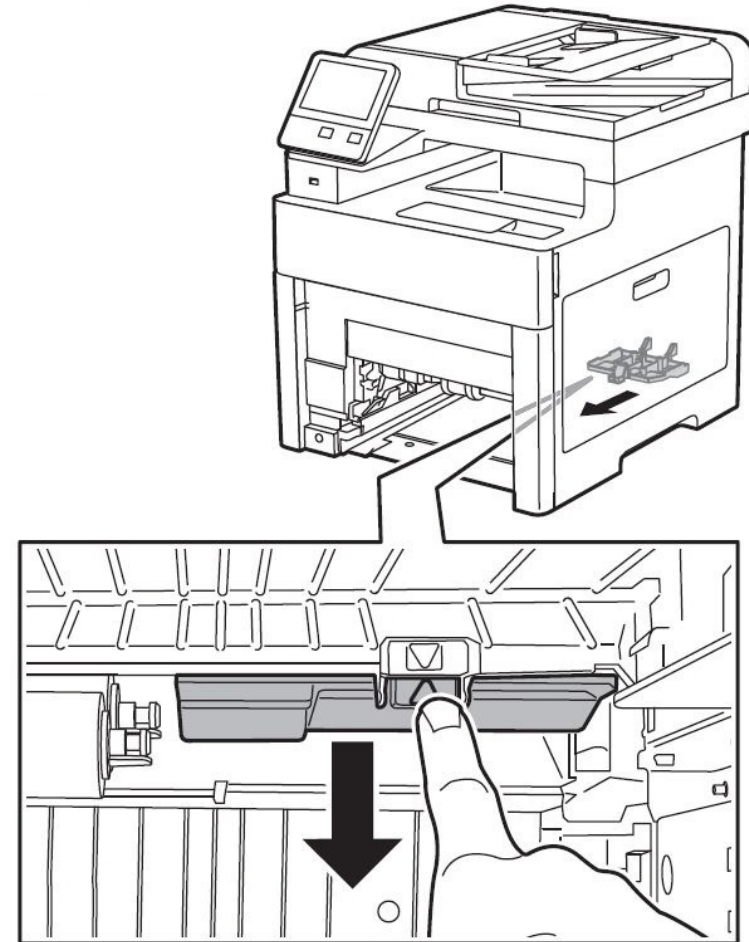
1. Remove the 550 Cassette Assembly; [REP 9.1](#).
2. Remove the Main Bypass Tray Assembly; [REP 13.5](#).
3. Refer to [Figure 1](#) to remove the Upper Feed Chute.

Figure 1 Remove the Upper Feed Chute

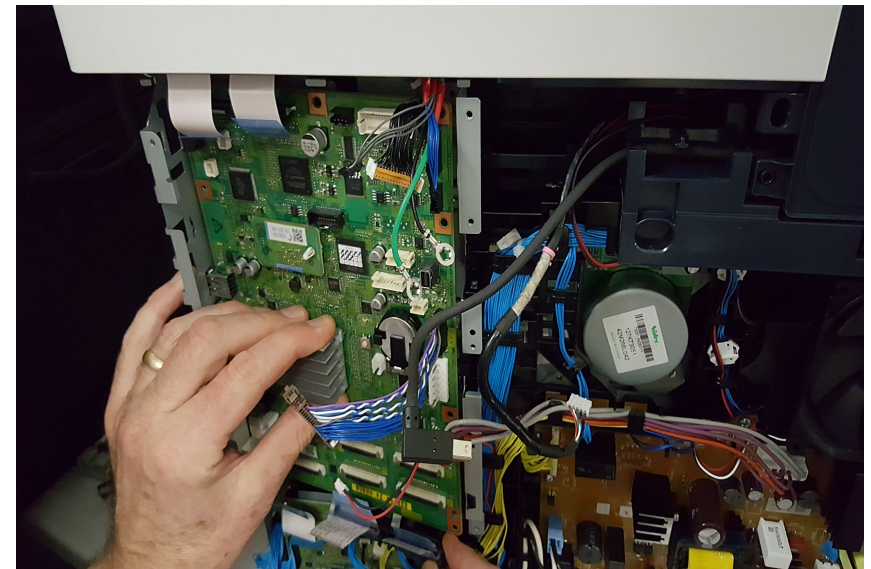
Figure 4 Lift the Bottom Right Corner

- b. Lift the bottom right corner of the ESS PWB from the ESS frame, [Figure 4](#).

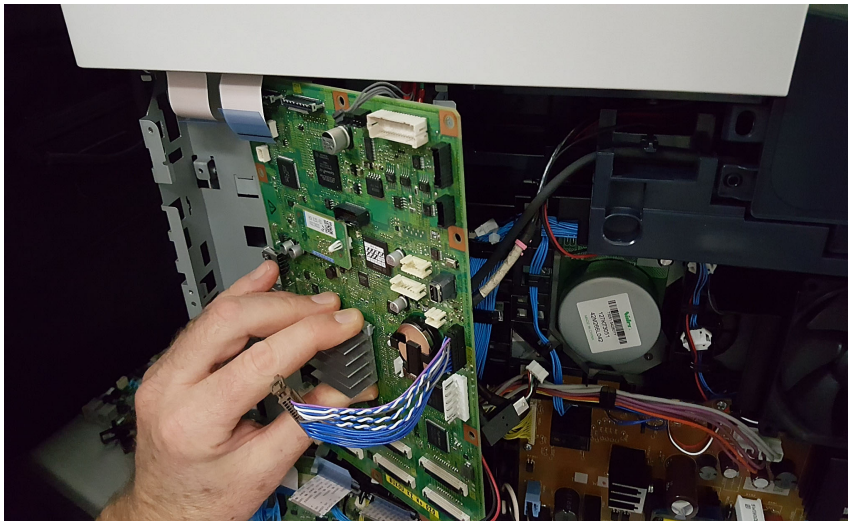
Figure 6 Remove the ESS PWB

d. Remove the ESS PWB from the ESS frame entirely, [Figure 6](#).

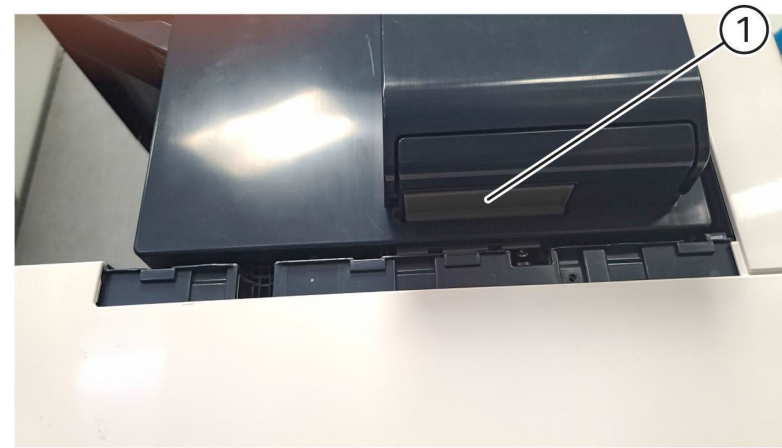
E-8-0938-A

3. Press the latch (1) to release the finisher, then slide the finisher to the right and remove from the machine, [Figure 3](#).

Figure 3 Finisher removal

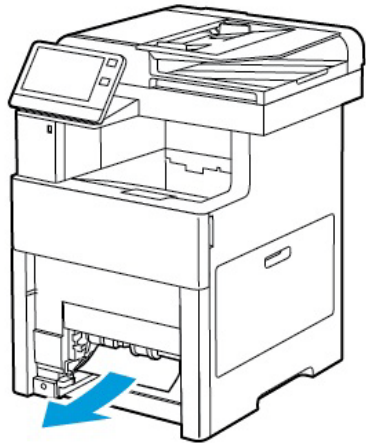
Figure 2 Clear the media path and output tray (C505/C605)

1. Refer to the following figures to clear the media path and output trays.
 - Figure 1 C500/C600
 - Figure 2 C505/C605
 - Figure 3 C505/C605 with optional 550 sheet feeder
 - Figure 4 Remove the optional feeder from the printer

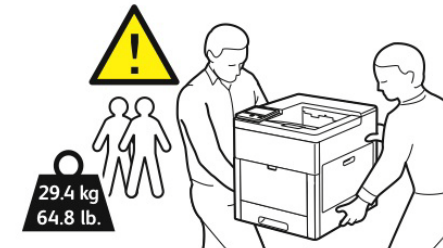
Figure 3 Printer Lifting Technique (C500/C600)

7. Lift and carry the printer as shown in [Figure 3](#) and [Figure 4](#).

- When moving the printer, do not tilt it more than 10 degrees to the front, back, left, or right. Tilting the printer more than 10 degrees can cause toner spillage.

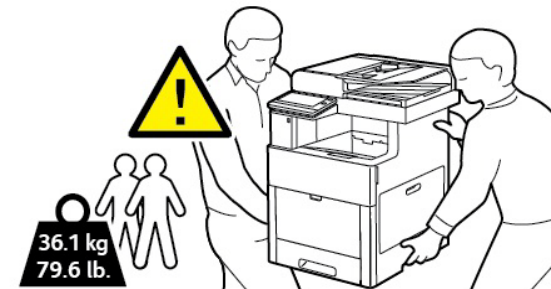
Figure 4 Printer Lifting Technique (C505/C605/C605_Tall)

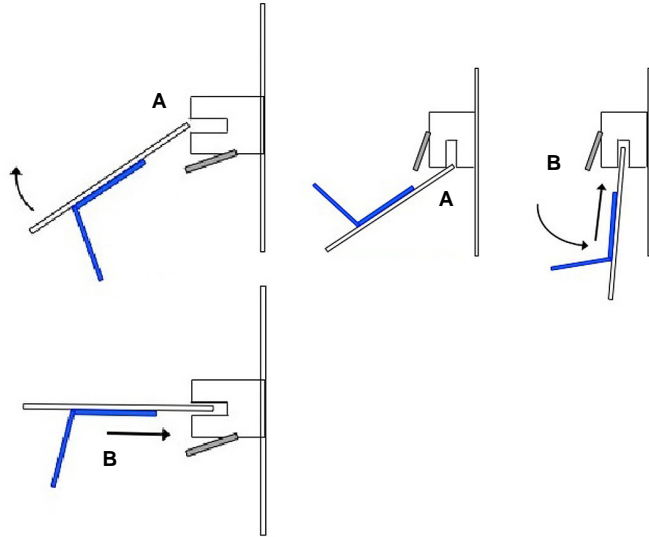
3. Use the blue reinforcing tab to very carefully connect the FFC cable, [Figure 2](#):
 - a. Position the FFC cable at an angle (A), then centrally (B) in the slot of the connector.
 - b. While aligning the FFC cable with the slot, firmly push the FFC cable into the connector (B). The release lever will close and a click will be heard when the FFC cable is fully inserted.

Figure 2 FCC cable connect

NOTE: Two types of surface mounted connectors are shown in [Figure 2](#).

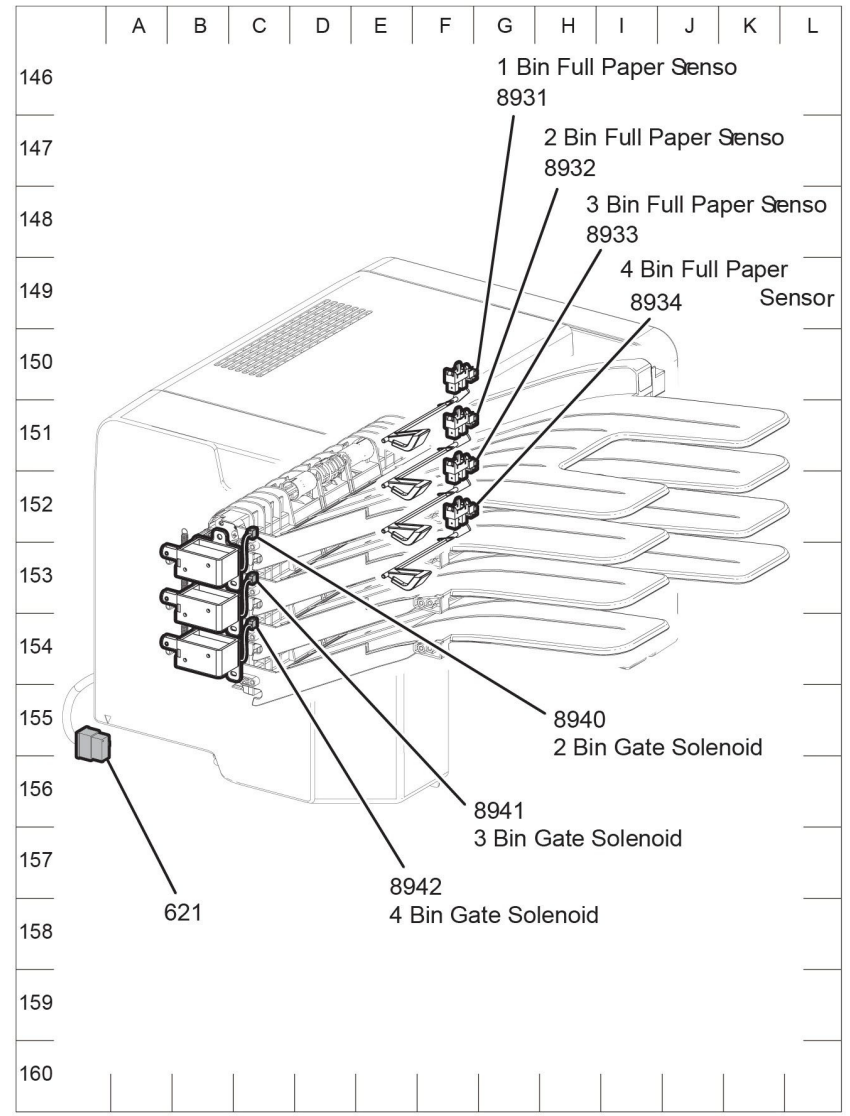
Figure 2 Connector locations (1/2)

P/J	Coordinates	Description
P/J8942	Figure 2, C-154	Connects harness assembly TRANS S and bin-4 gate solenoid
P/J8943	Figure 3, J-155	Connects harness assembly vertical LED and harness assembly vertical sensor

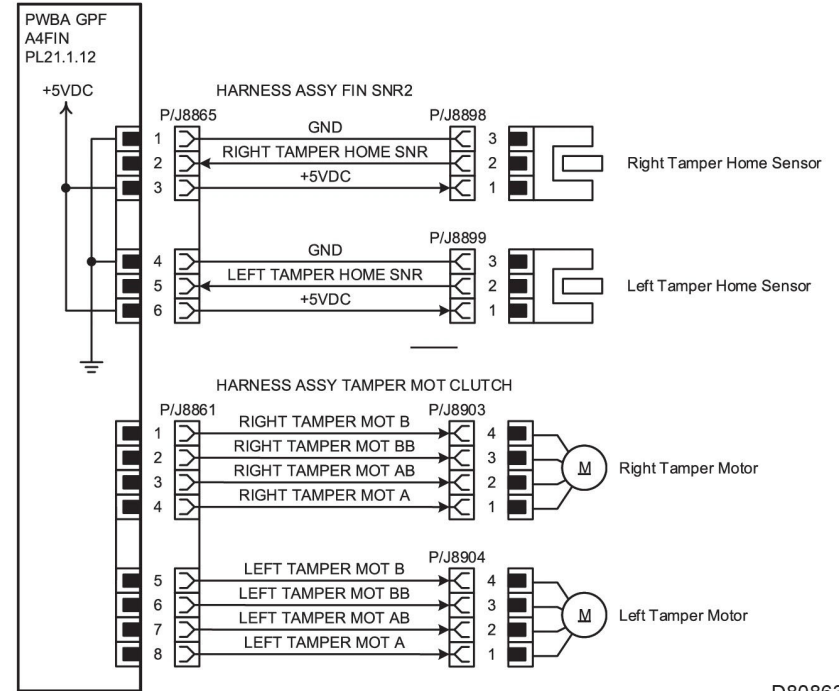
D80863

Figure 4 Tamper connection diagram

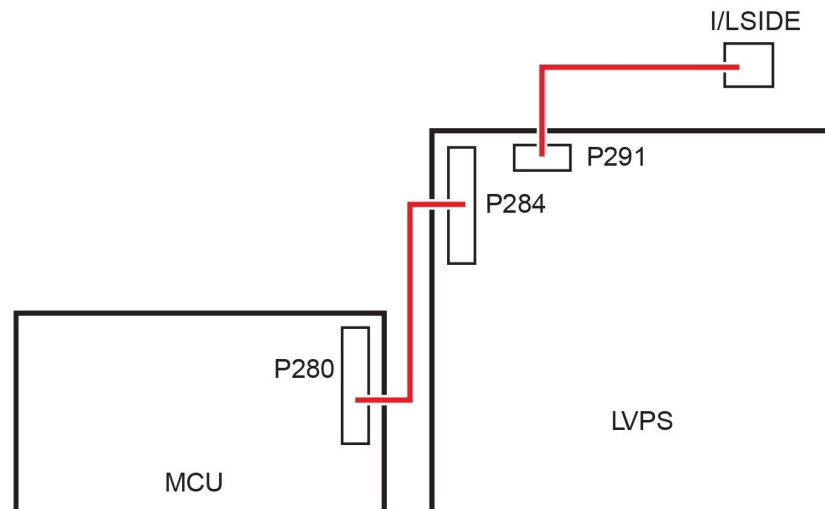
D80914

Figure 21 I/L side, MCU, LVPS

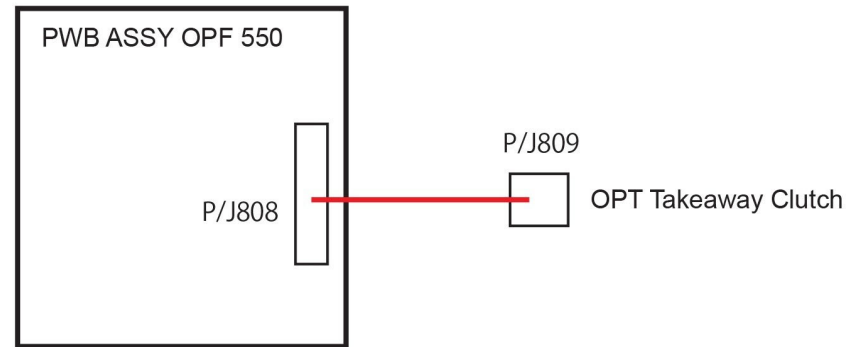
D80919

Figure 26 550 OPF PWB, OPF take away clutch

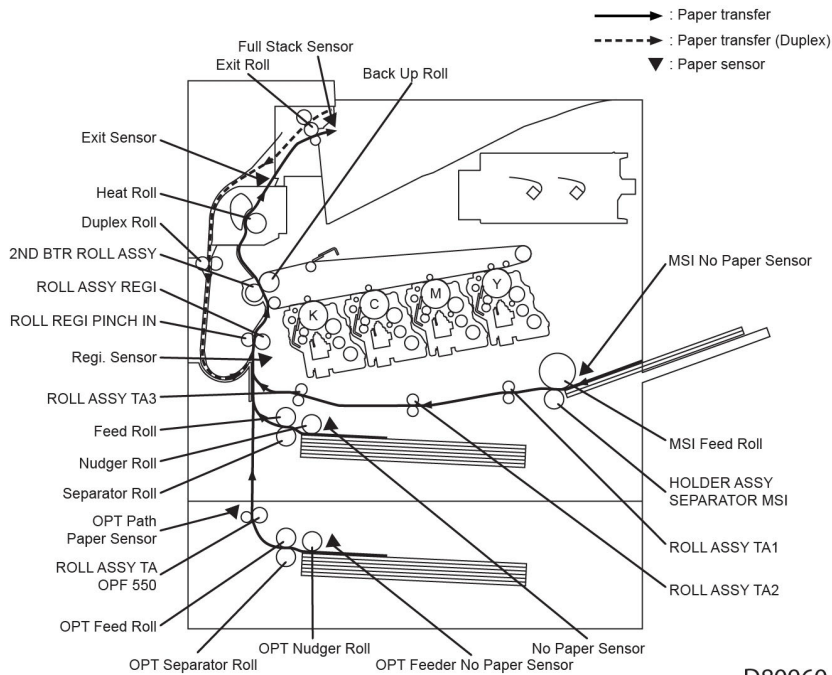
D80960

Figure 1 shows the paper feed layout when the tray module is installed, and the components relevant to paper feed.

Figure 1 Paper path layout
