Xerox® VersaLink® C625 **Multifunction Color Printer** **Service Manual**

Service Manual

705P01470

Revised Update: May 2023

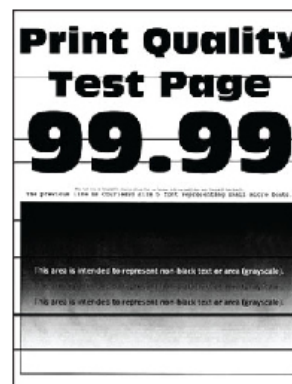
IQ7 Horizontal Colored Lines or Banding RAP

Figure 1 Horizontal Colored Lines

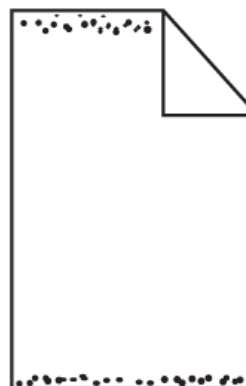
IQ9 Marks on Leading or Trailing Edges RAP

Figure 1 Marks on Leading or Trailing Edges

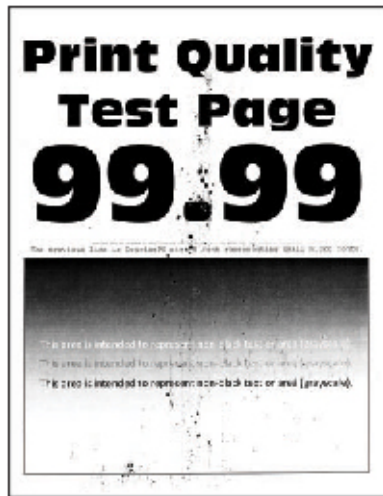
IQ10 Mottled Print and Dots RAP

Figure 1 Random Dark Spots

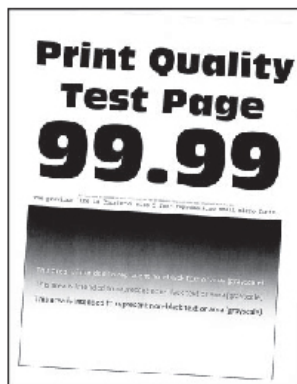
IQ11 Print Crooked or Skewed RAP

Figure 1 Skewed Print

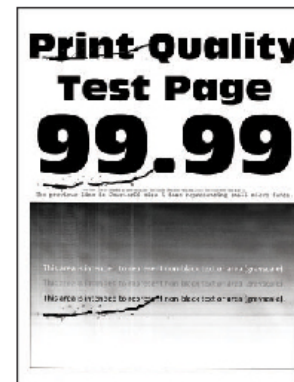
IQ12 Repeating Defects RAP

Figure 1 Repeating Defects

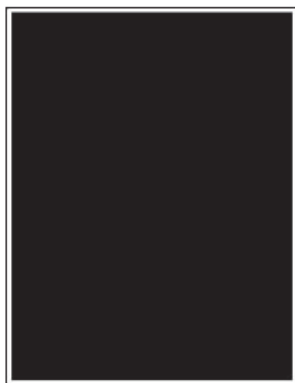
IQ13 Solid Color or Black Image RAP

Figure 1 Solid Color or Black Image

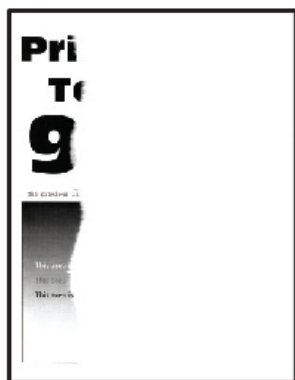
IQ14 Text or Images Cut Off RAP

Figure 1 Image Cut Off

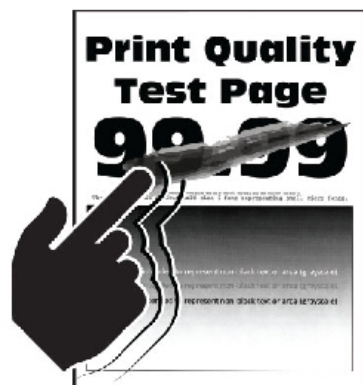
IQ15 Toner Easily Rubs Off RAP

Figure 1 Toner Easily Rubs Off

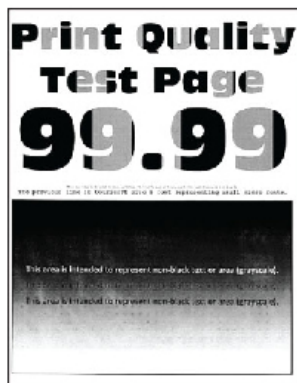
IQ16 Uneven Print Density RAP

Figure 1 Uneven Print

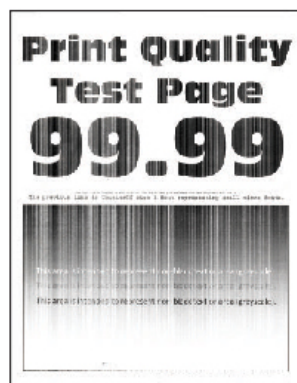
IQ17 Vertical Colored Lines or Banding RAP

Figure 1 Vertical Colored Lines

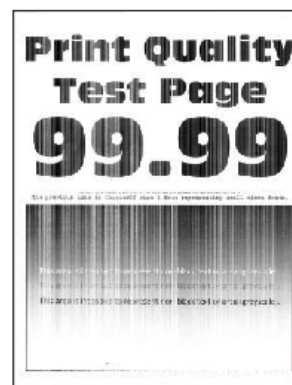
IQ18 Vertical White Lines RAP

Figure 1 Vertical White Lines

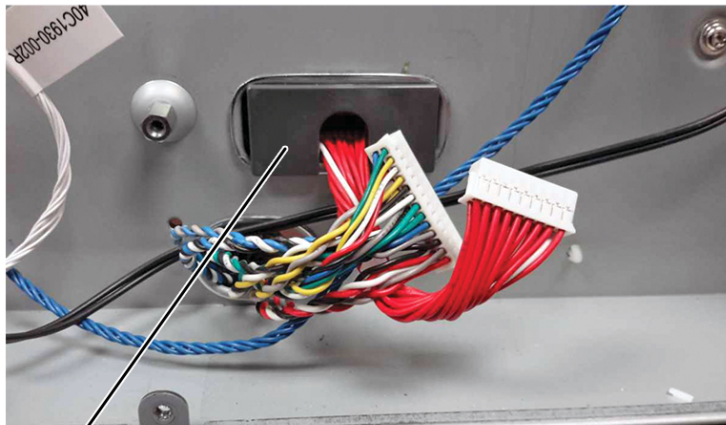
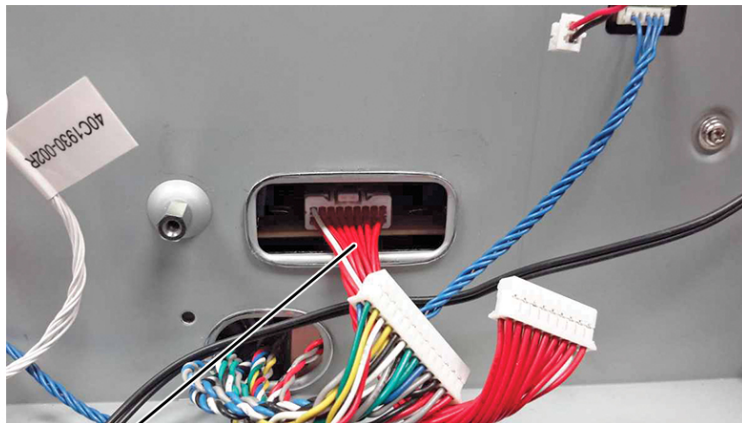
VLC625S_4075

1. Remove the left cover, [REP 28.17](#)
2. Remove the right cover, [REP 28.1](#)
3. Remove the controller PWB shield, [REP 3.1](#).
4. Press the latch (1) to release it, and then disconnect the cable (2).

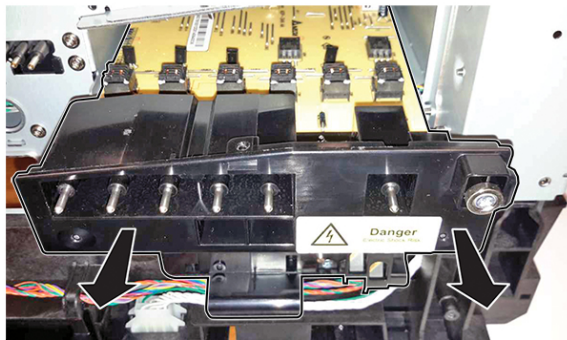
VLC625S_4078

6. At the opposite end of the HVPS, press down on the latch (4) and slide the HVPS inwards to release it.
7. Remove the HVPS.

Note: Press on the side of the toner contacts while removing the HVPS to fully release it.

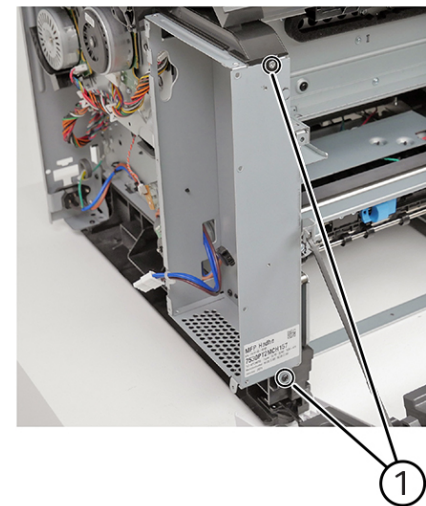
VLC625S_4041

1. Remove the fuser. See [REP 10.1](#).
2. Remove the transfer module. See [REP 90.9](#).
3. Remove the left cover. See [REP 28.17](#).
4. Remove the LVPS. See [REP 1.2](#).
5. Remove the two screws (1).

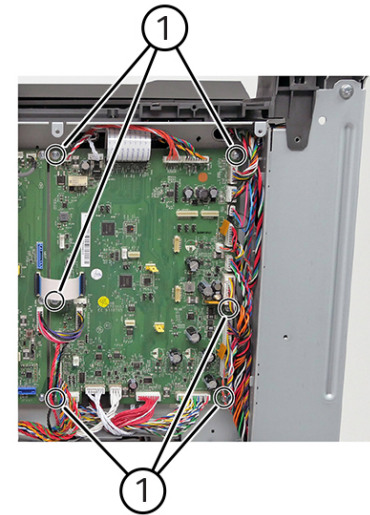
VLC625S_4150

1. Remove the controller PWB shield, [REP 3.1](#).
2. Disconnect all cables, then remove six screws (1).

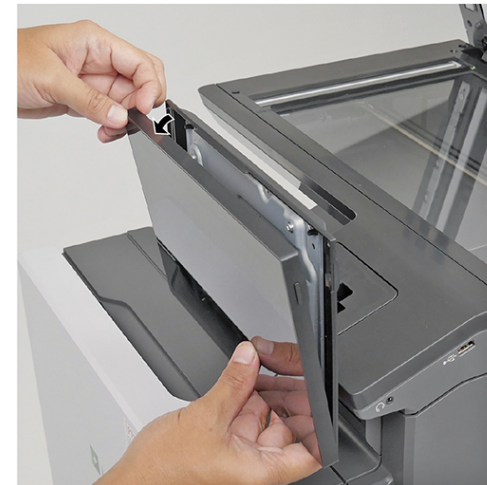
VLC625S_4111

2. Pry the control panel display to release, and then pull it to access the cable. Warning—Potential Damage: The FFC may get damaged if the control panel display is dropped. Make sure to hold

the control panel display after releasing it.

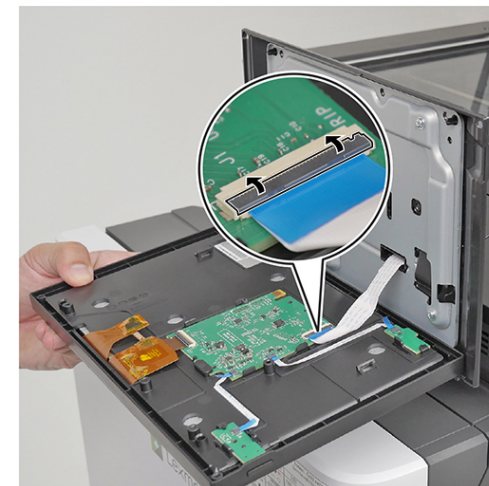
VLC625S_4112

3. Unlock the clip, and then disconnect the cable.

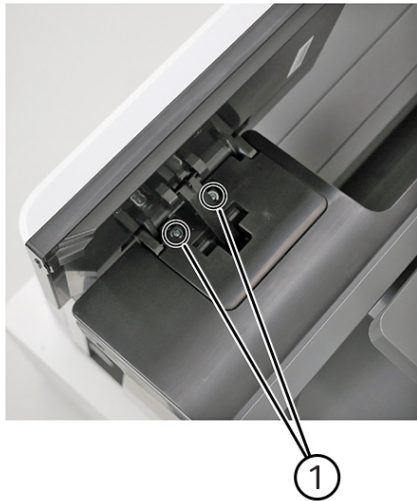
VLC625S_4113

4. Remove two screws (1), then remove the control panel base.

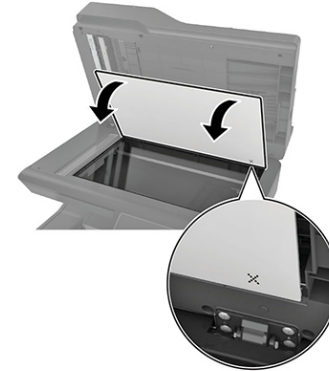
VLC625S_4191

- a. Place the white area of the new scanner glass pad facedown on the scanner glass, and then remove the backing on the tape.

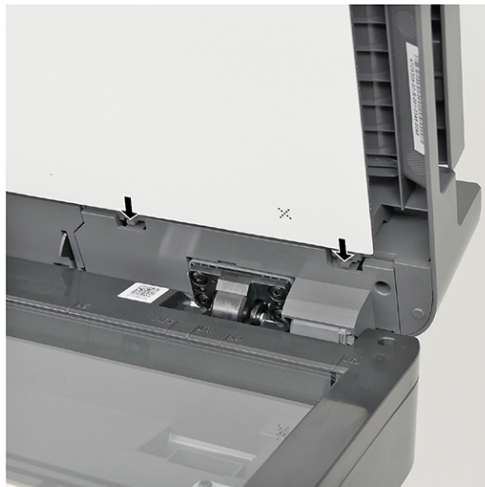
VLC625S_4196

1. Release the latches, and then remove the cover.

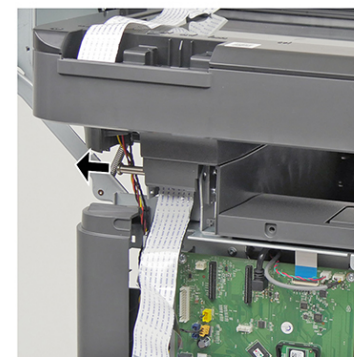
VLC625S_4201

6. Using pliers, remove the two retainers.

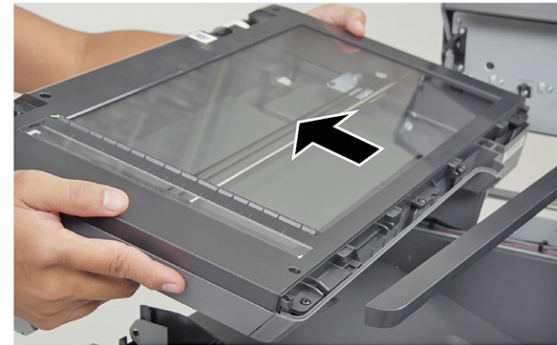
VLC625S_4203

9. Pry the cover to release, and then remove the flatbed scanner.

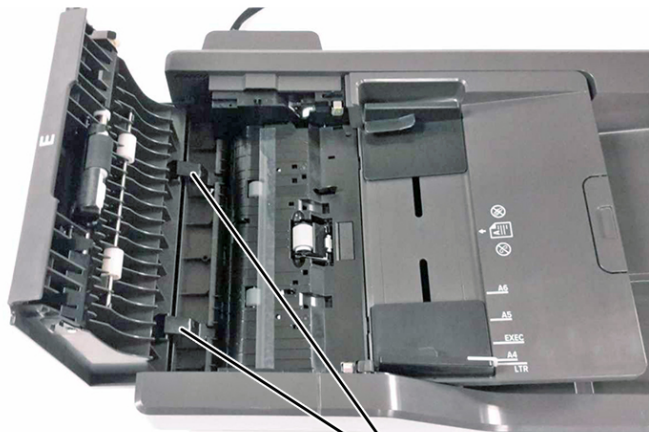
VLC625S_4212

1. Open the DADF top cover. Note: Pay attention to the position of the tabs (1).

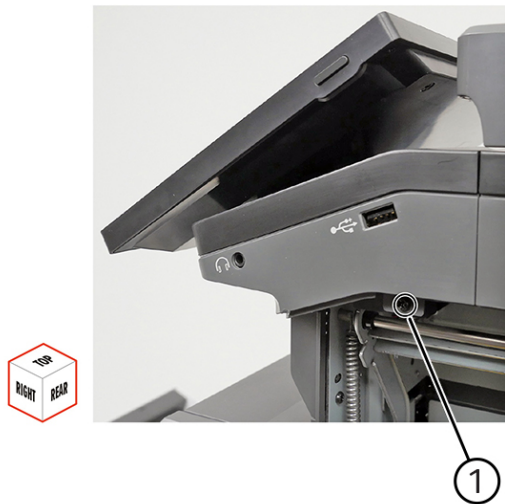
VLC625S_4057

1. Open the cartridge door.
2. Remove the screw (1), and then remove the cover.

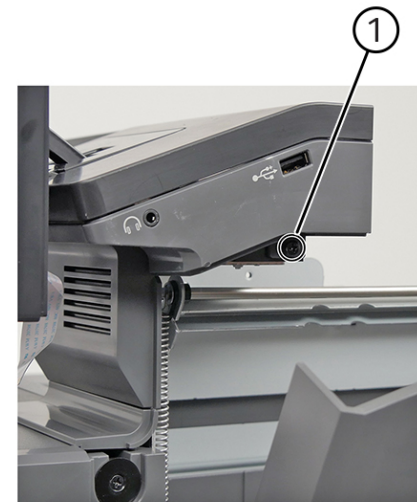
VLC625S_4058

1. Remove the scanner rear right cover. See [PL 28.15 item 9](#)
2. Remove the scanner rear left cover. See [PL 28.15 item 8](#)
3. Remove the DADF. See [REP 5.3](#).
4. Remove the controller PWB shield. See [REP 3.1](#).
5. Remove the flatbed scanner. See [REP 5.4](#).
6. Remove or loosen the top cover. See [REP 28.8](#).
7. Remove the screw (1), and then remove the cover.

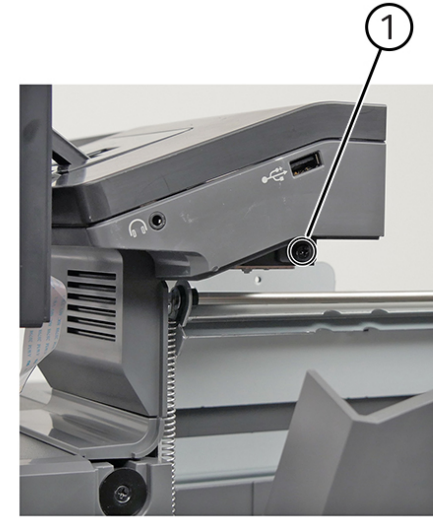
Figure 2 Cover screw removal

4. Remove the controller PWB shield. See [REP 3.1](#).
5. Remove the flatbed scanner. See [REP 5.4](#).
6. Remove or loosen the top cover. See [REP 28.8](#).
7. Remove the screw (1), then remove the cover, Figure 2

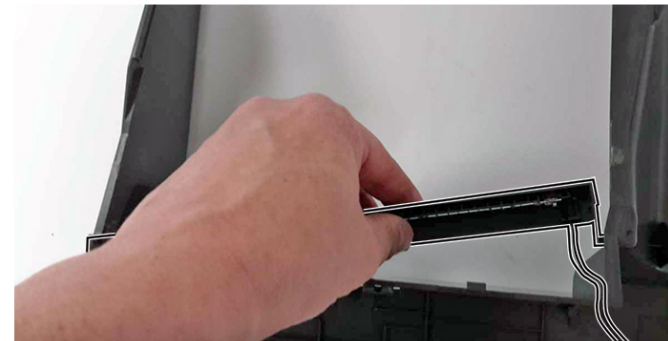
18. Remove the cover.

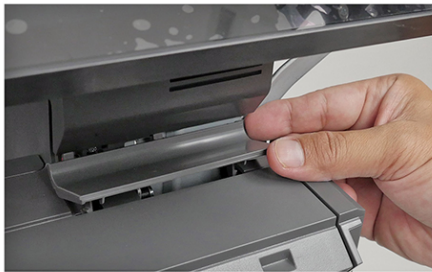
1. Remove the USB cover. See [REP 28.4](#).
2. Remove the badge cover.

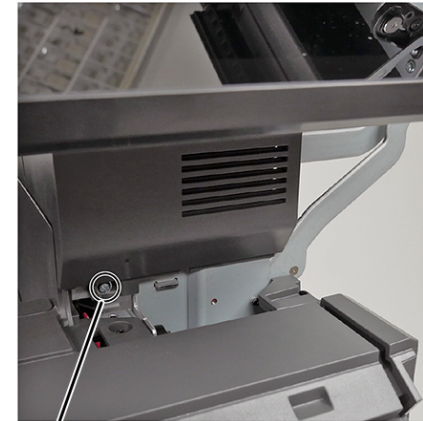
3. Remove the screw (1).

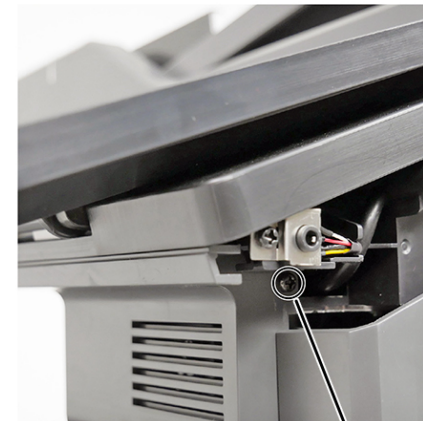
4. Remove the screw (2).

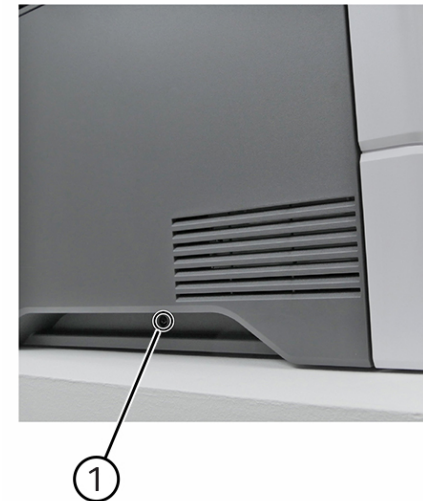
1. Remove one screw (1).

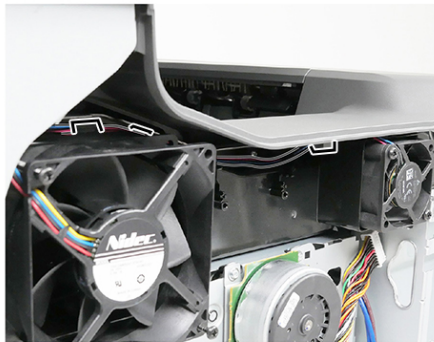
VLC625S_4028

5. Release the cable from its guides, and then remove the fan.

Note: Pay attention to the cable route.

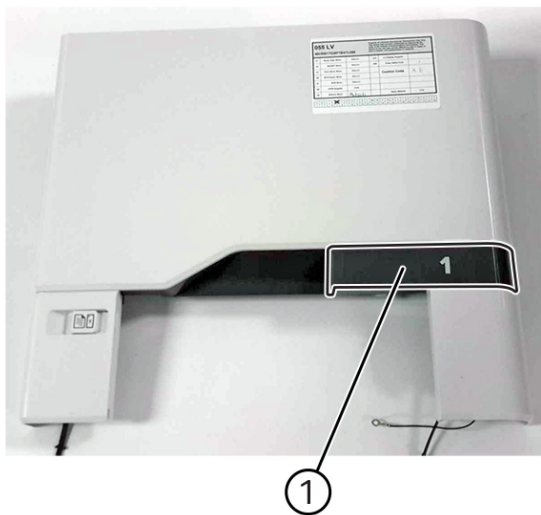
VLC625S_4144

1. Remove the front door. See [REP 28.10](#).
2. Remove the pivot shaft. See [REP 80.10](#).
3. Remove duplex inner guide. See [REP 80.13](#).
4. Remove the tray indicator (1).

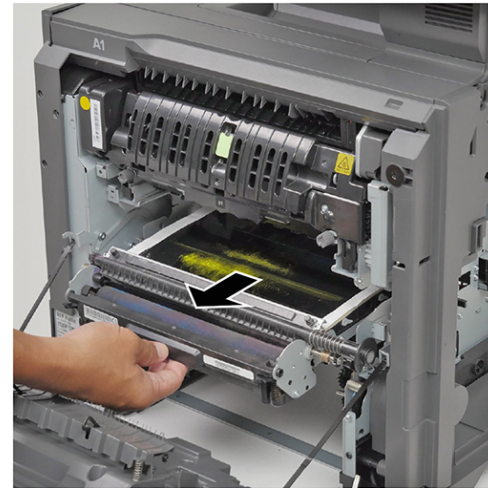
VLC625S_4097

6. Remove the transfer module.

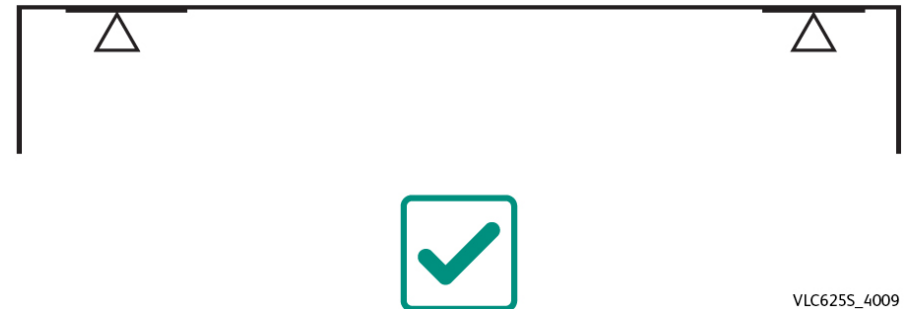
The following test page result shows a properly aligned printhead:

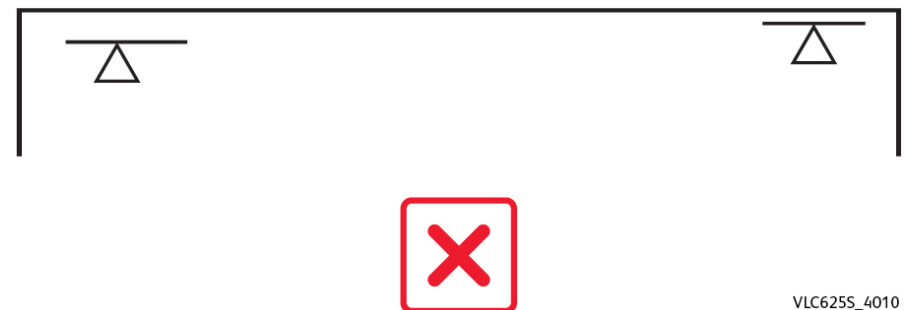
In most cases, the printhead is skewed counterclockwise, as shown in the following test page result.

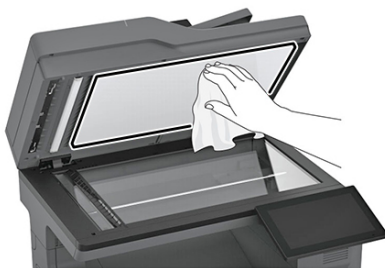
- Scanner glass pad, [Figure 3](#).

Figure 3 Scanner glass pad

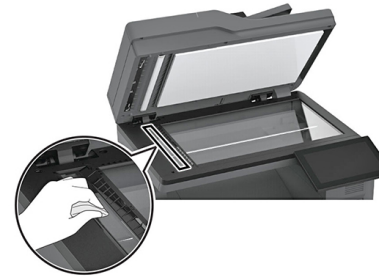
- DADF glass, [Figure 4](#).

Figure 4 DADF glass

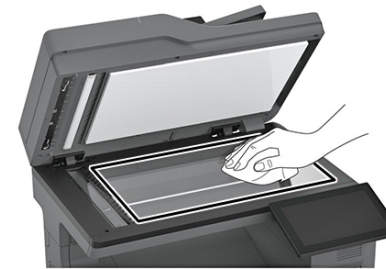
Figure 5 Scanner glass

- Scanner glass, [Figure 5](#).

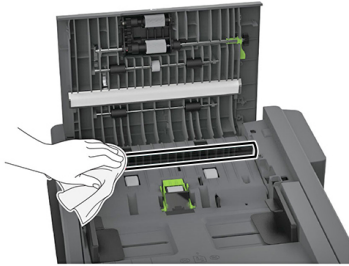
Figure 7 DADF glass in door C

- DADF glass in door C, [Figure 7](#).

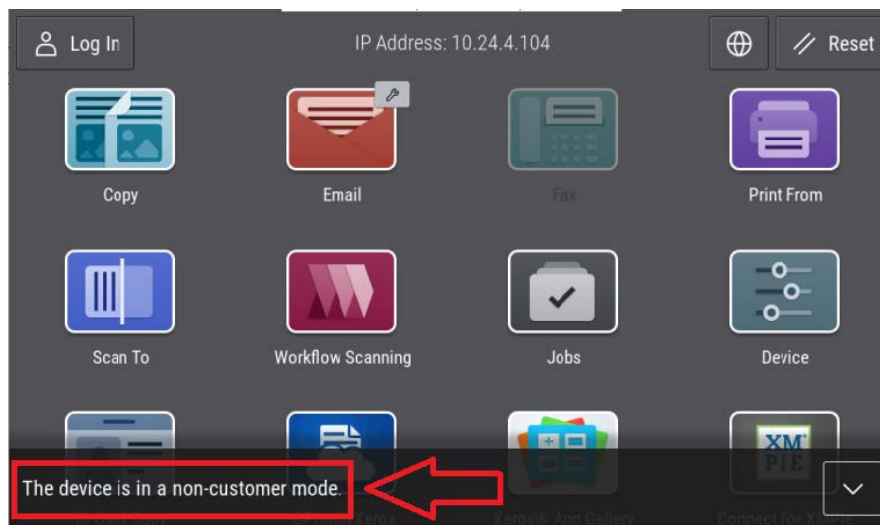
Figure 1 UI Display

During some service procedures, NVM 616-014 may be set to the default value of 0. When this occurs, the screen will display the message **The device is in a non-customer mode**, Figure 1.

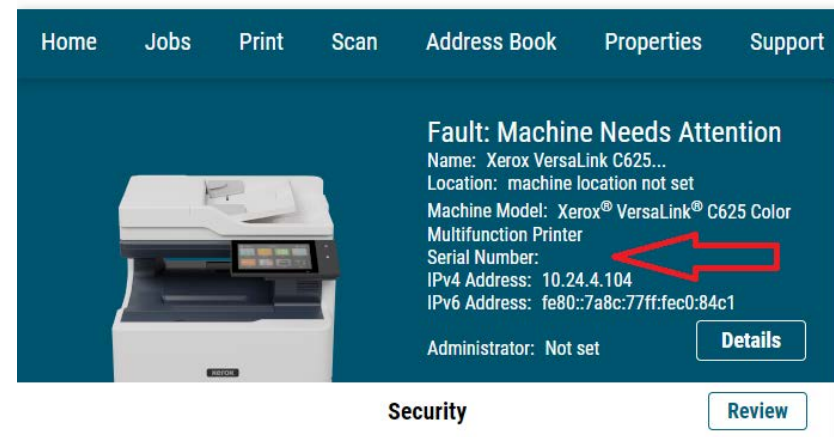
Figure 2 EWS UI Screen

The EWS UI screen will show no serial number, Figure 2.

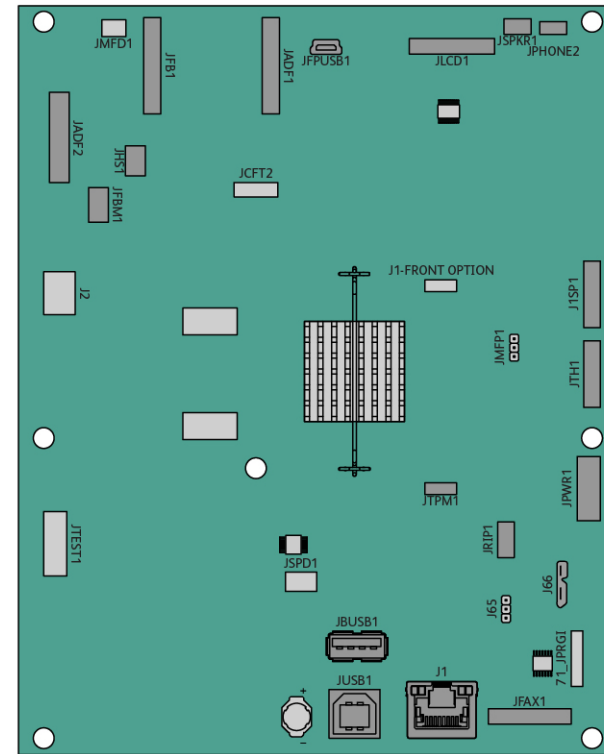
Figure 1 Controller PWB

Controller PWB

Location: PL 3.05 item 2

- Controller PWB Connectors, [Figure 1](#).
- Drive PWB Connectors, [Figure 2](#).
- LVPS Connectors, [Figure 3](#).
- Sensor Locations, [Figure 4](#)

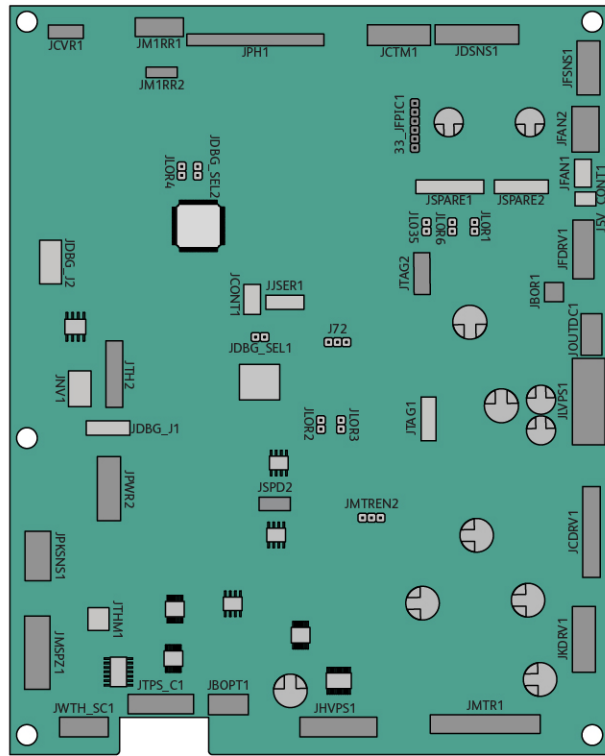
Figure 2 Motor Drive PWB
LVPS

Motor Drive PWB

Location: PL 1.10 item 3

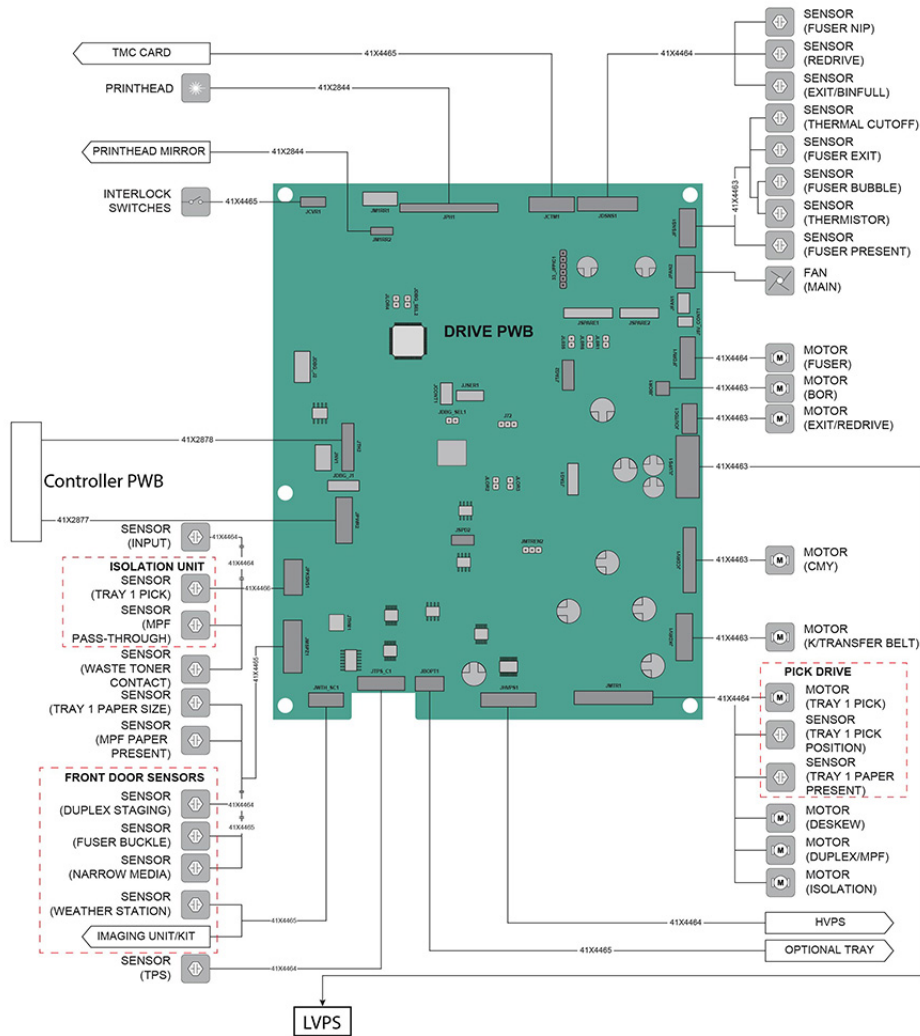
WD2 - Drive PWB Wiring Diagram

WD2 Drive PWB Wiring Diagram
