WorkCentre 5335 Family Service Documentation

705P01303

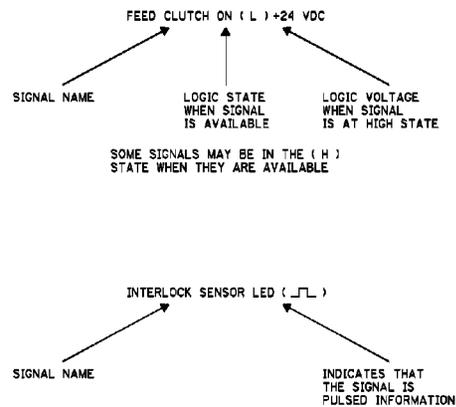
Figure 7 Signal Nomenclature

Refer to [Figure 7](#) for an example of Signal Nomenclature used in Circuit Diagrams and BSDs.

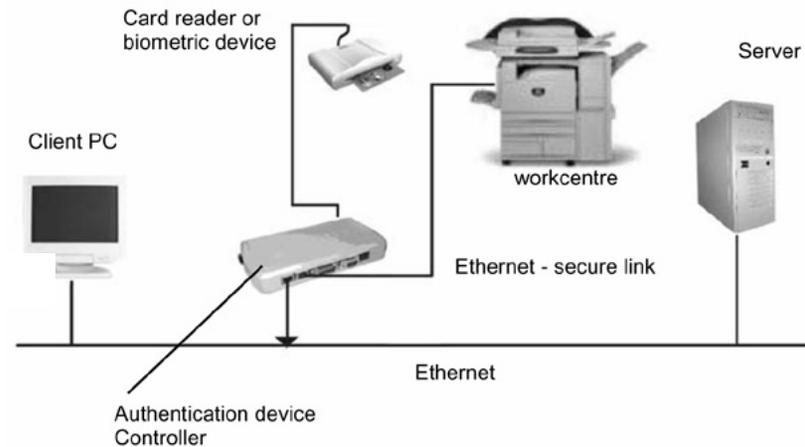
Figure 1 Network Diagram

Xerox Secure Access uses an external device, such as a card reader or biometric device, to authorize access to the machine. This reader then passes the information to the controller, which handles the authentication process including, which GUI screens are displayed, accepting GUI responses, that defines their content and order. The controller can pass user identities and passwords directly to the machine after gathering the data from an external server. All communication is via a secure network link, [Figure 1 Network Diagram](#).

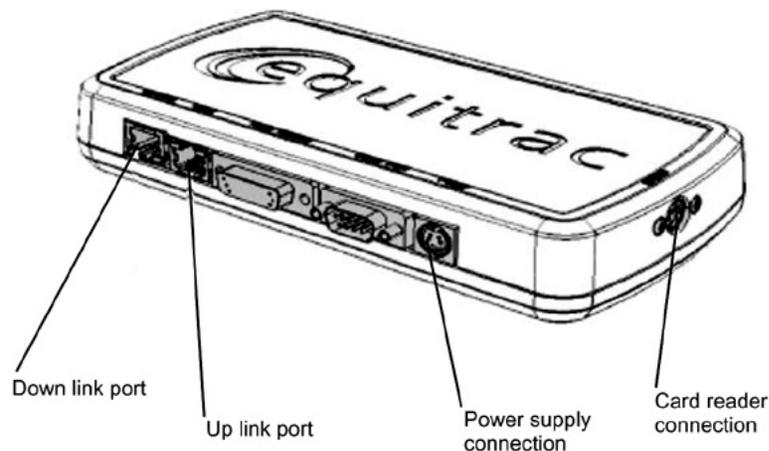
Figure 2 Authentication Device

The primary failure modes are power problems or failed hardware components. The symptom of these failures can be detected by observing the Led's on the Secure Access Authentication Device, [Figure 2](#).

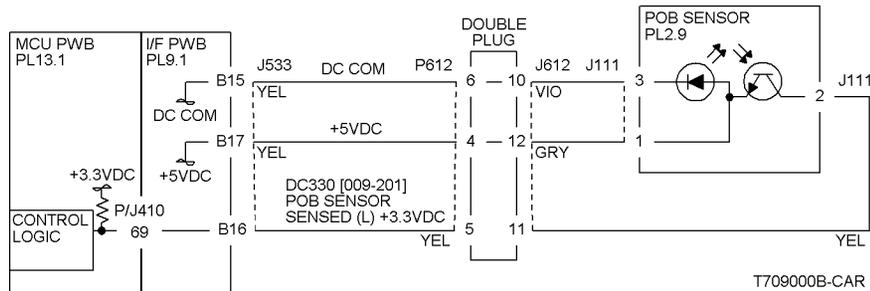
Figure 1 Typical Reflective Sensor Circuit Diagram

A | **B** | **C** | **D**
 Disconnect the sensor. Use a jumper wire to connect the output wire from the sensor (typically pin 2 on a 3 pin connector) to DC COM or GND. **The display changes from H to L.**
Y | **N**
 There is either an open circuit or a failed PWB. Use the Circuit Diagram to trace the output wire to the PWB. If the wire is OK, replace the PWB.
 Replace the sensor.
 Disconnect the sensor. **The display indicates H.**
Y | **N**
 When sensors are unplugged, the input at the PWB should always be high if there is no harness short or PWB failure. Check the output wire from the sensor (typically pin 2 on a 3 pin connector) to the PWB for a short circuit. If the wire is good, replace the PWB. Figure 1 represents a typical sensor for this machine.
 The sensor is shorted. Replace the sensor.
 Look for unusual sources of contamination.

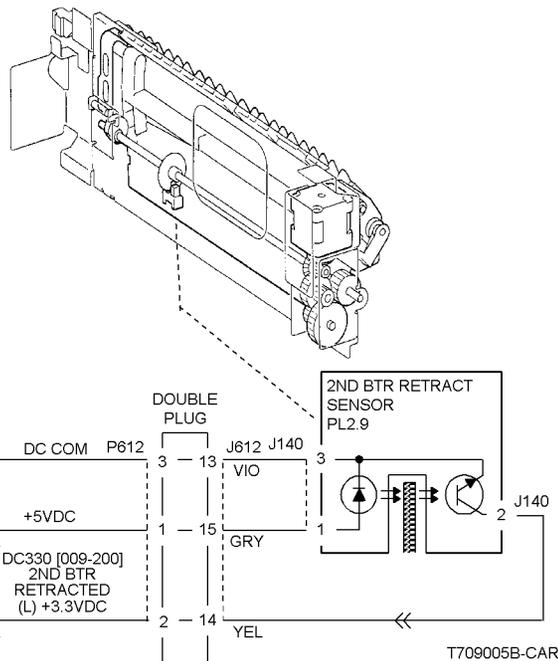
Figure 1 Typical Transmissive Sensor Circuit Diagram

The sensor and the circuit appear to operate normally. Check the adjustment of the sensor. Clean the sensor. Check the sensor actuator/flag for proper operation. Check for intermittent connections, shorted, or open wires. If the problem continues, replace the sensor.

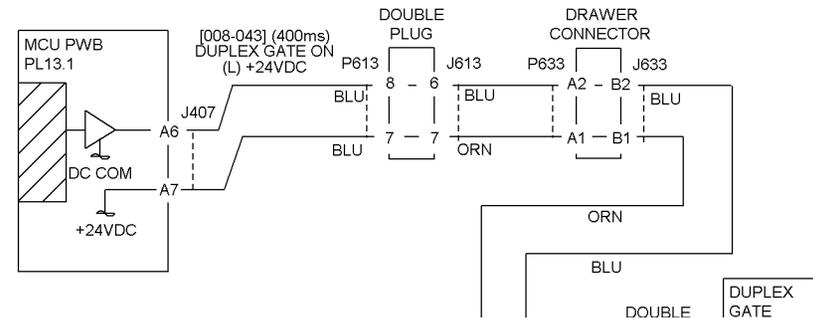
Figure 1 Typical Solenoid/Clutch Circuit Diagram

There is a short circuit on the switched leg (J407 pin A6 in the example) from the solenoid or clutch. Check the wire for a short circuit to GND. If the wire is OK, replace the solenoid. If the problem persists, replace the controlling PWB.

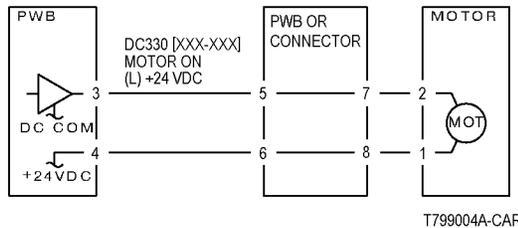
Figure 1 Motor CD

Check the wire between the PWB Pin 3 and the Motor Pin 2 for an open circuit or poor contact.

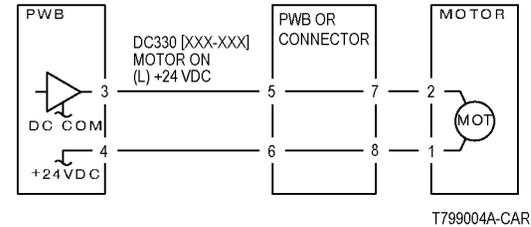
Figure 1 Motor CD

Check the wire between the connector Pin 3 and the motor Pin 2 for a short circuit. If the check is OK, replace the motor.

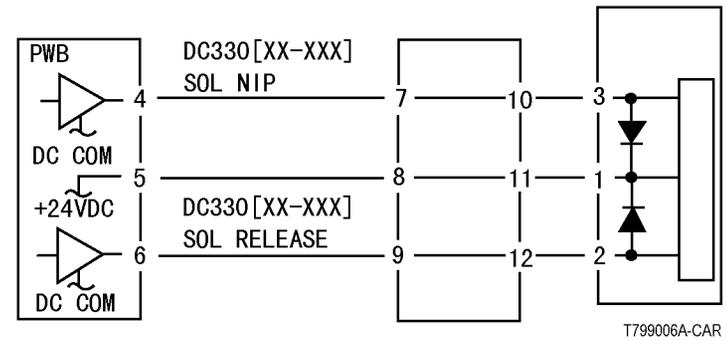
Figure 1 Nip Solenoid CD

Check the wire between the PWB Pin 6 and the Nip/Release Solenoid Pin 2 for an open circuit or poor contact.

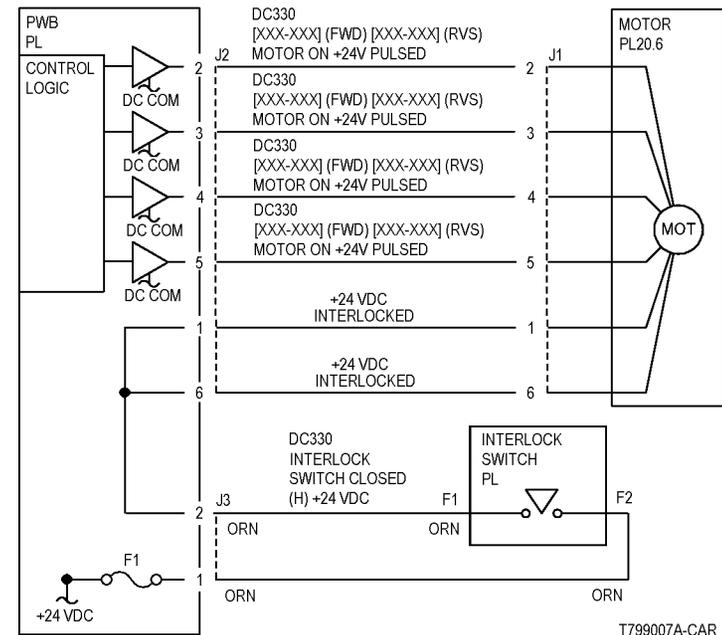
Figure 1 Motor CD

Check the motor wires for obvious damage. If the wires are good, replace the Motor.

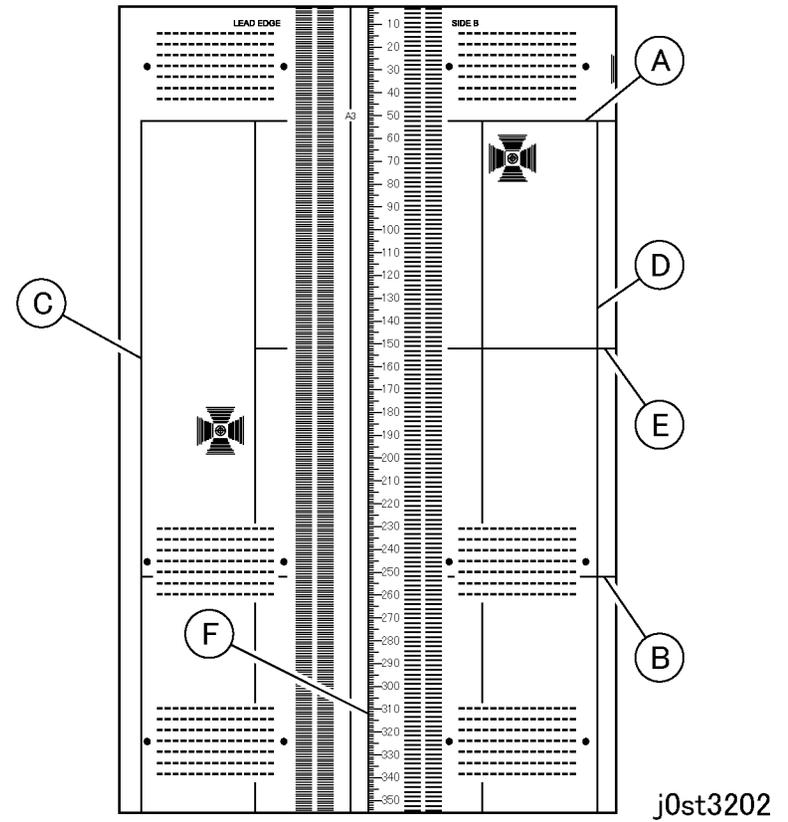
Figure 2 Standard Test Pattern (Side B)

Side B (Figure 2) is used to evaluate skips and smears, resolution, and magnification.

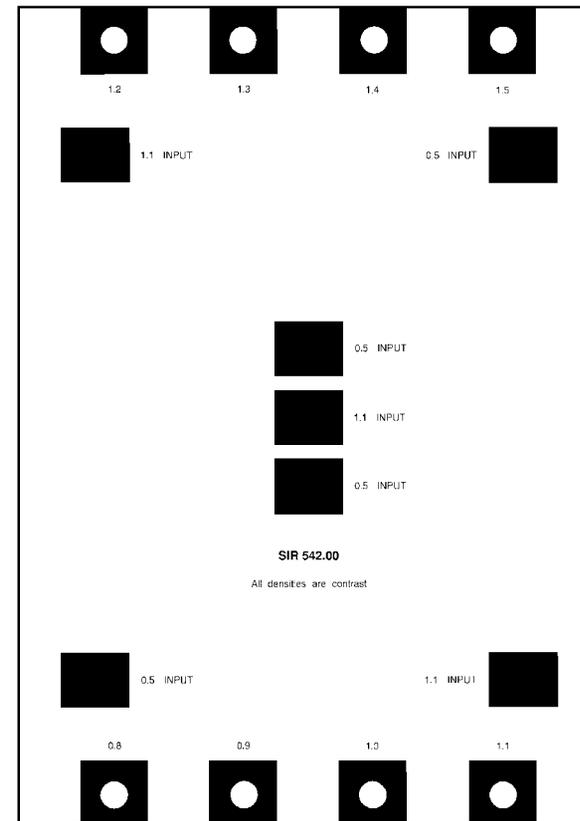
Figure 3 Output Reference Guide, SIR542.00

This test document serves as a reference guide for measuring the solid area density of the Side A copies of the test pattern, 82P524 and 82P521 (Figure 3).

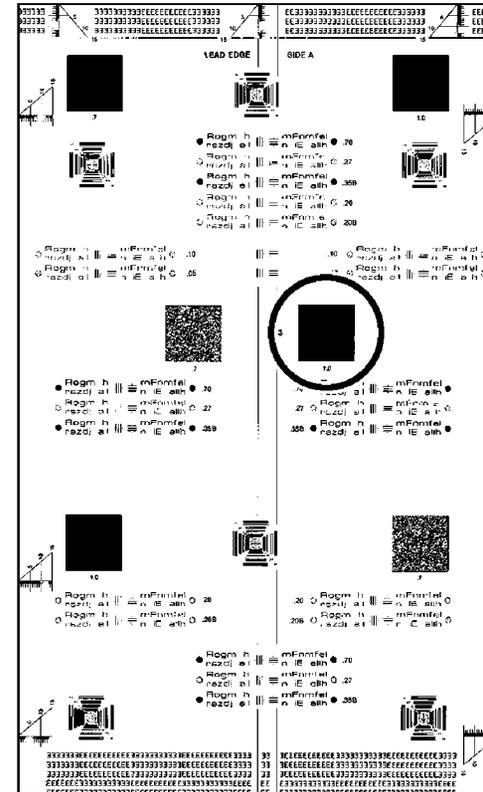
Figure 1 Standard Test Pattern (Side A)

Using Side A of the Standard Test Pattern (Figure 1), evaluate the solid area density per the following table.

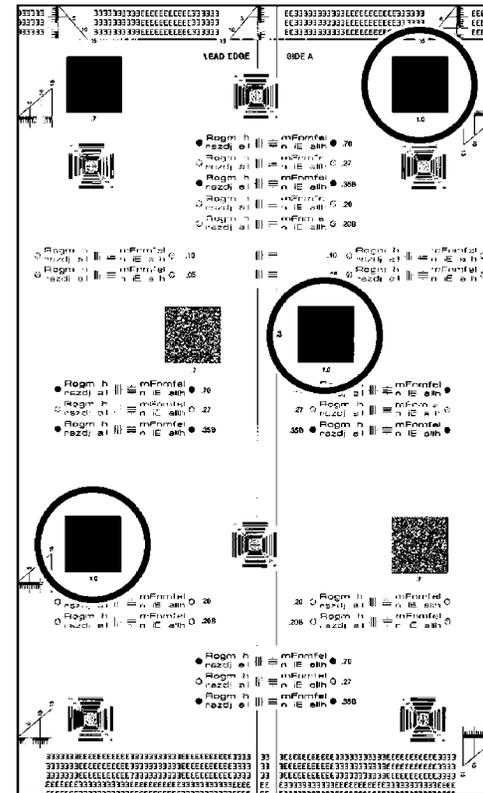
Figure 1 Standard Test Pattern 1.0 Blocks

The density of all the 1.0 blocks are same (Figure 1).

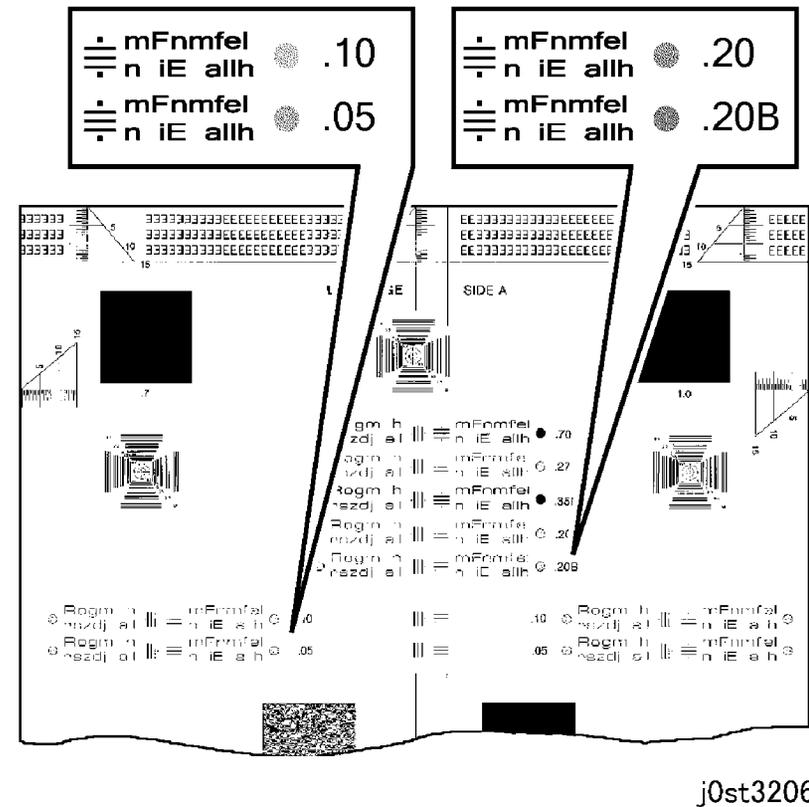
Figure 1 Exposure Level

In the Standard Copy mode, and with the copy darkness control set at the middle of the scale, the 0.20G(Or0.20B) line pair must be copied completely.

In the Standard Copy mode, and with the copy darkness control set two level lighter from the middle of the scale, the 0.10 line pair should not copy at all (Figure 1).

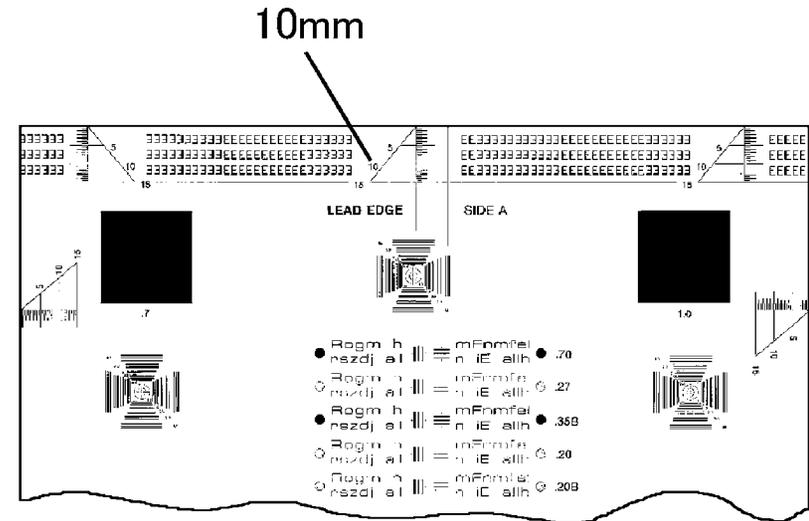
Figure 1 Lead Edge Registration

The center 10 mm reference line on the copy must be 10 mm (plus or minus the ranges listed in the following charts) from the lead edge of a 100% copy (Figure 1).

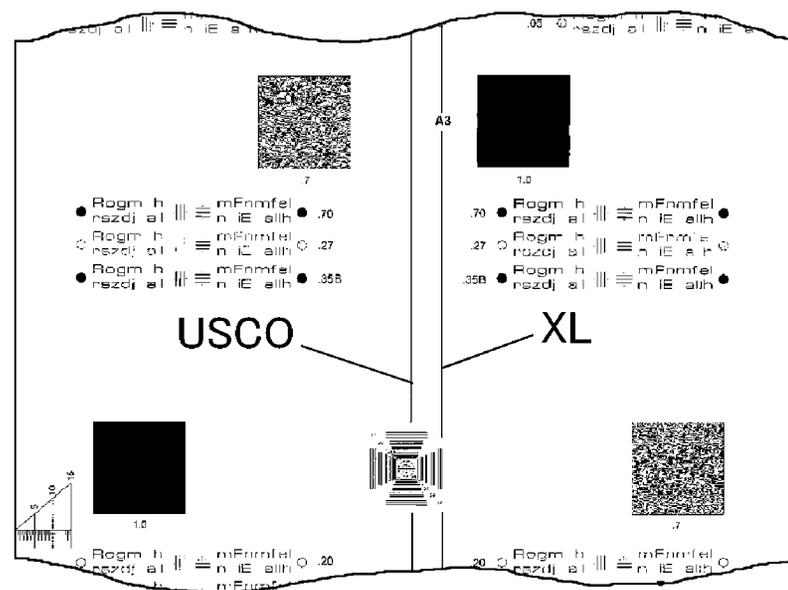
Figure 1 Side Edge Registration

For a copy that is folded in half, the crease in the copy should be within the following ranges from the center line of a 100% copy (Figure 1).

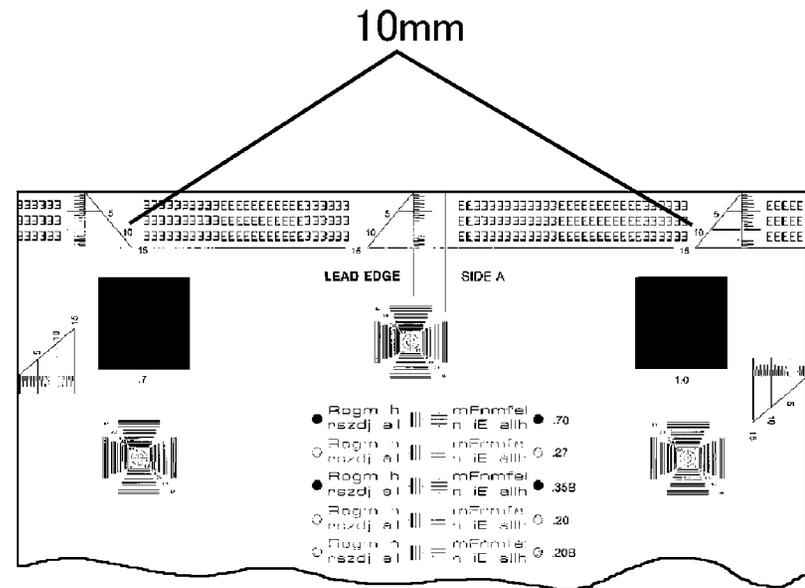
Figure 1 Skew

Skew must be within the following ranges (with respect to each other) at the two 10 mm reference lines shown (Figure 1).

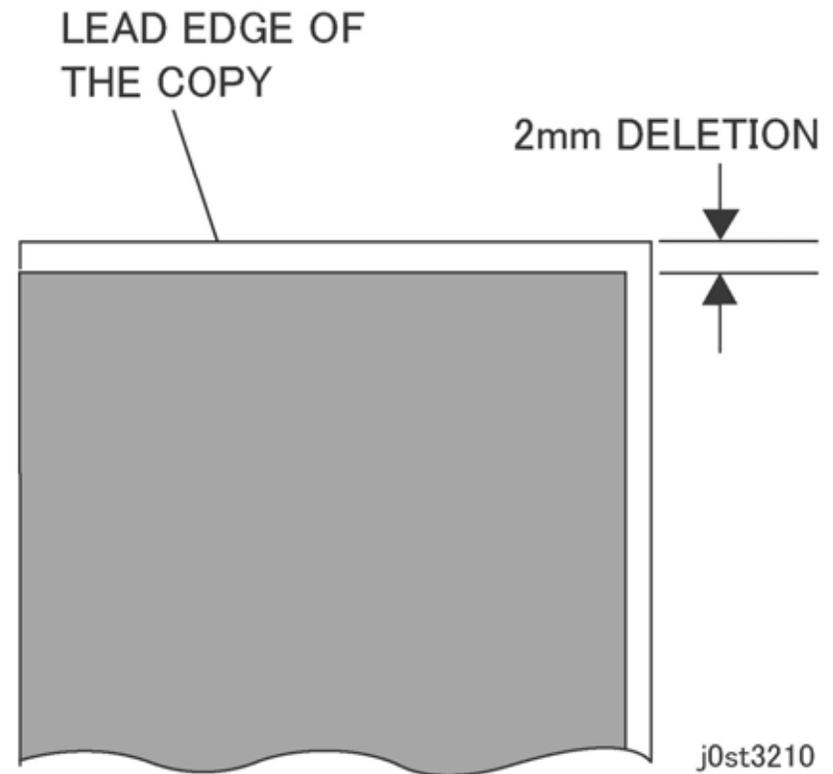
Figure 1 Lead Edge Deletion

The image deleted intentionally along the lead edge must be 2.0 mm from the lead edge of the copy (Figure 1). (maximum is 4mm)

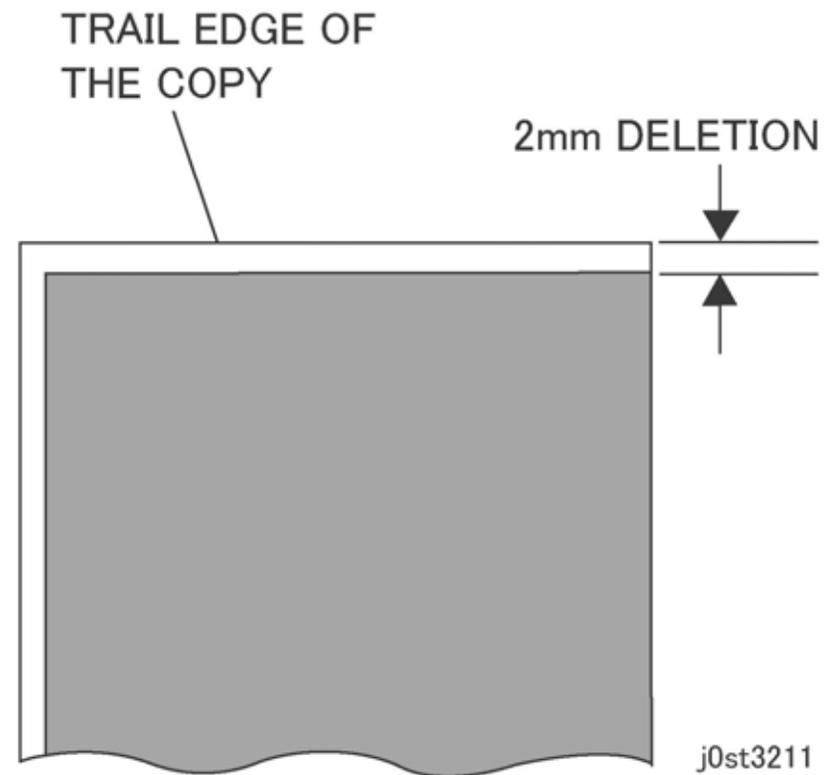
Figure 1 Trail Edge Deletion

The image deleted intentionally along the trail edge must be 2mm from the trail edge of the copy (Figure 1). (maximum is 4mm)

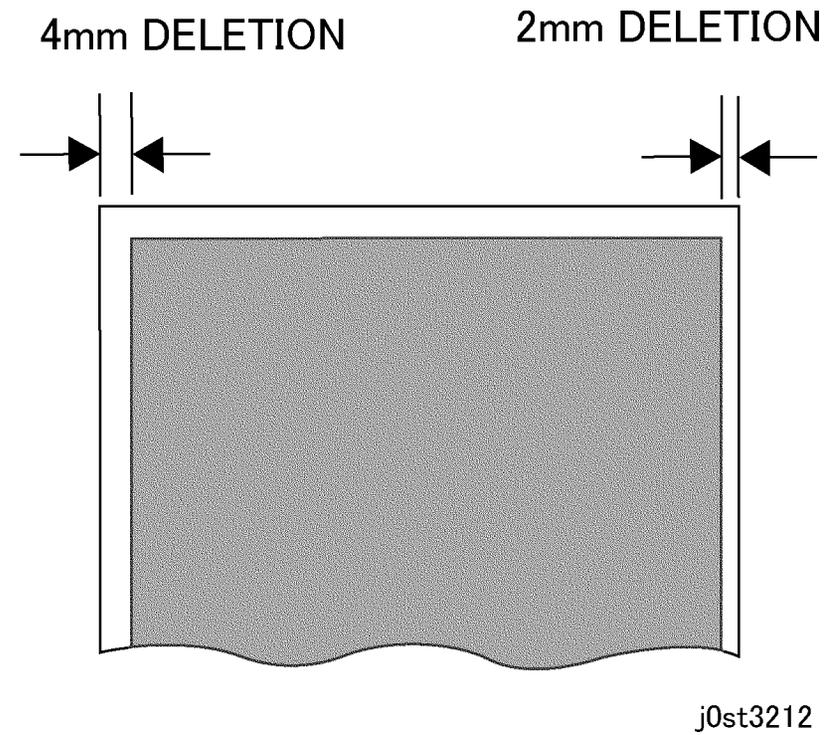
Figure 1 Side Edge Deletion

The image deleted intentionally along both of side edge must be 2mm from the side edge of the copy (Figure 1). (maximum is 4mm)

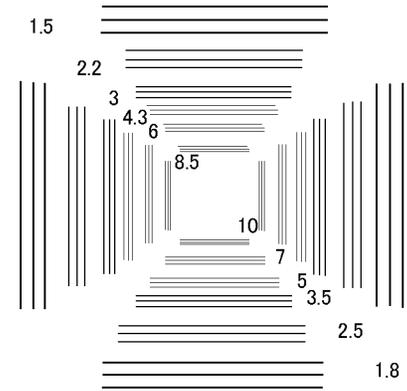
Figure 1 Resolution

It is also required that the designated LP/mm lines be resolved in the top-to-bottom direction and the side-to-side direction over the entire copy (Figure 1).

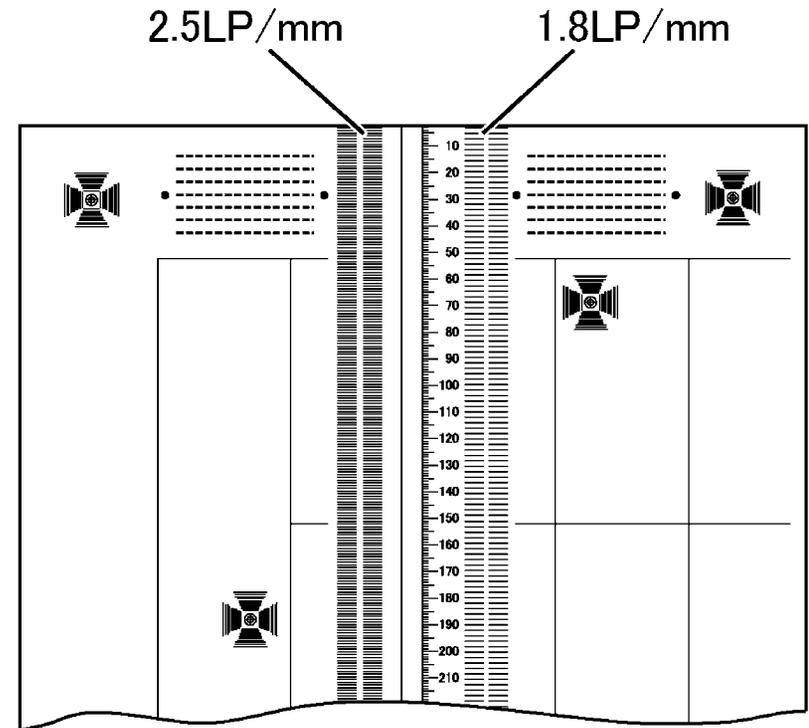
Figure 1 Skips and Smears

Except for the first 2 mm from the lead edge of the copy, 2.5 ladder chart must be completely resolved (Figure 1).

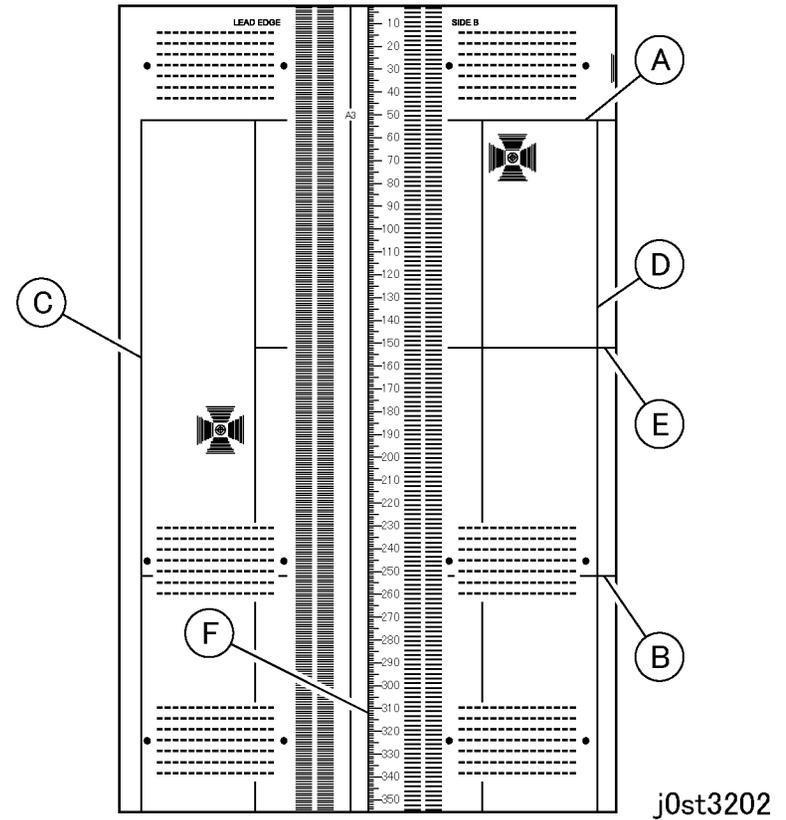
Figure 1 Areas of Side B to be Measured

Refer to **Figure 1** for the areas to be measured. For 65% and 101%, use areas A and B for the magnification in the lead edge to trail edge direction; and areas C and D for magnification in the front to rear direction. For 154% use areas A and E for magnification in the lead edge to trail edge direction; and areas C and F for magnification in the front to rear direction.

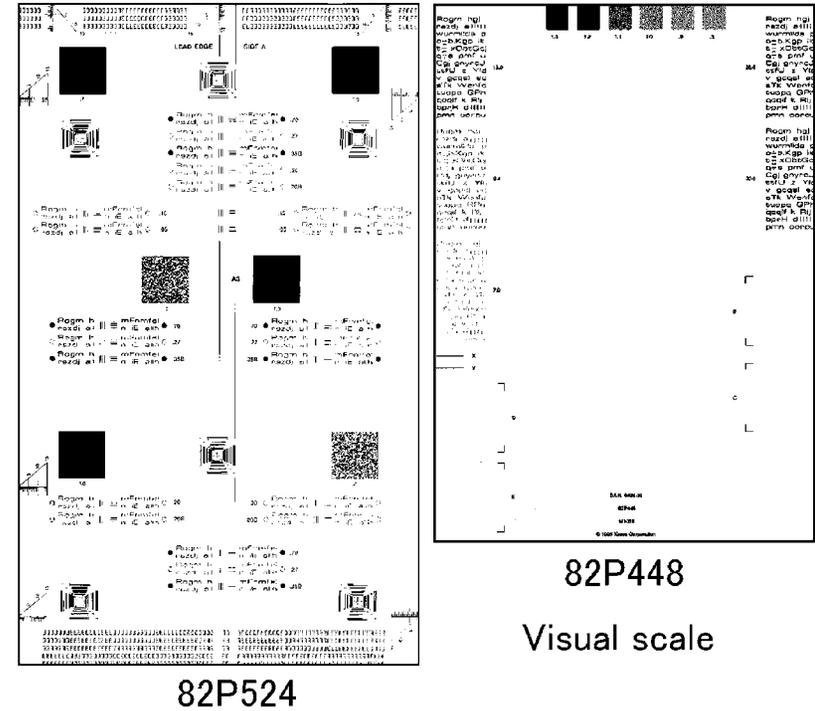
Figure 1 Test Pattern

Compare images of the test pattern, (Figure 1) made from the document glass, with the visual scale, 82P448.

The background of the images must not be darker than the reference area "C" (Figure 1).

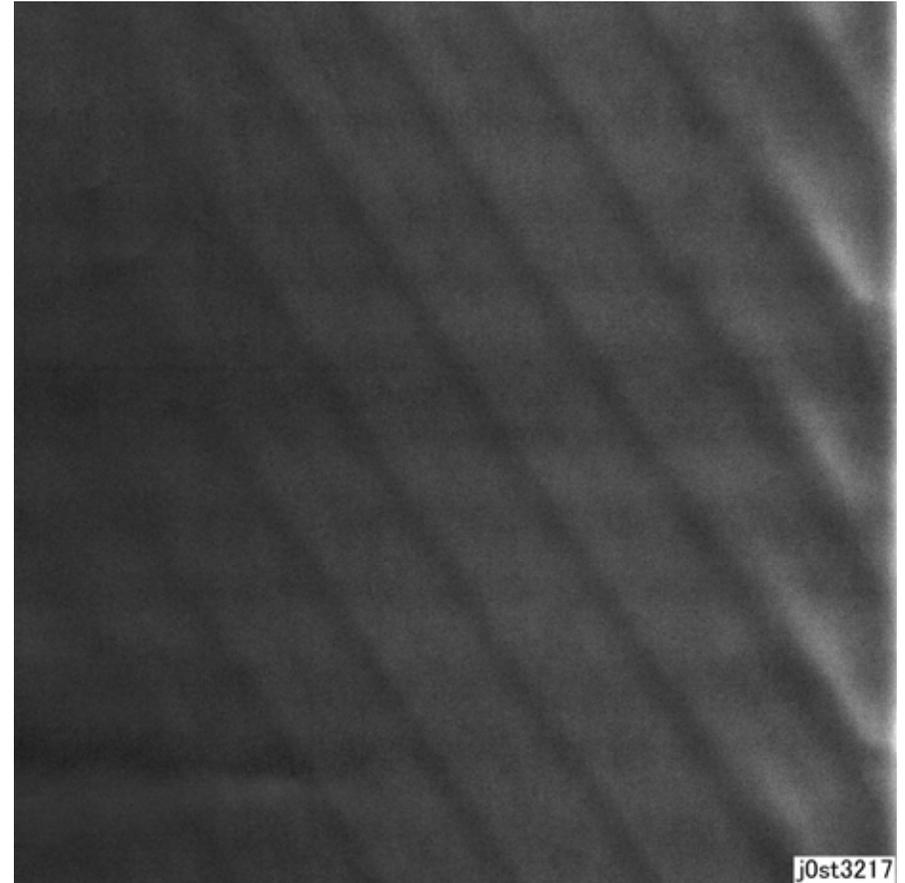
Figure 1 Auger Mark Defect Sample

NOTE: This may occur immediately after a new CRU is installed. -> Correct by feeding a few sheets of paper.

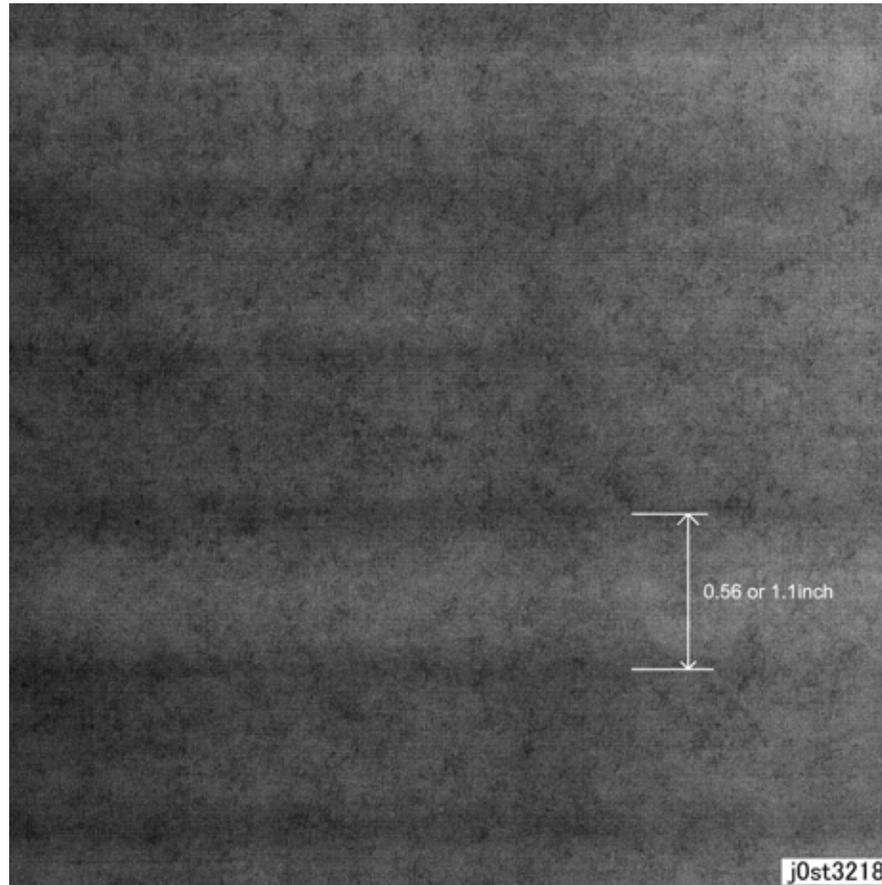
Figure 1 Strobing (28mm or 14mm Pitch Density) Defect Sample

1. Replace the Xerographic Cartridge(PL 8.1).

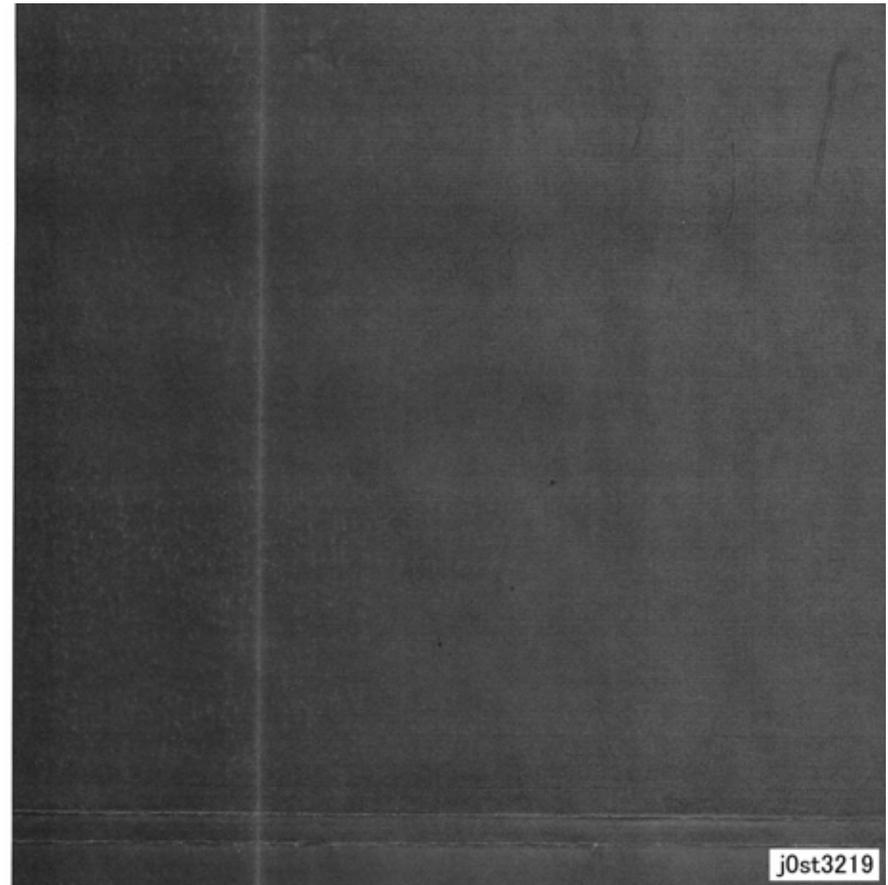
Figure 1 White Streaks (Process Direction) Defect Sample

1. Clean the light path between the ROS and the Xerographic Cartridge and the seal glass.
2. Replace the Xerographic Cartridge (PL 8.1).

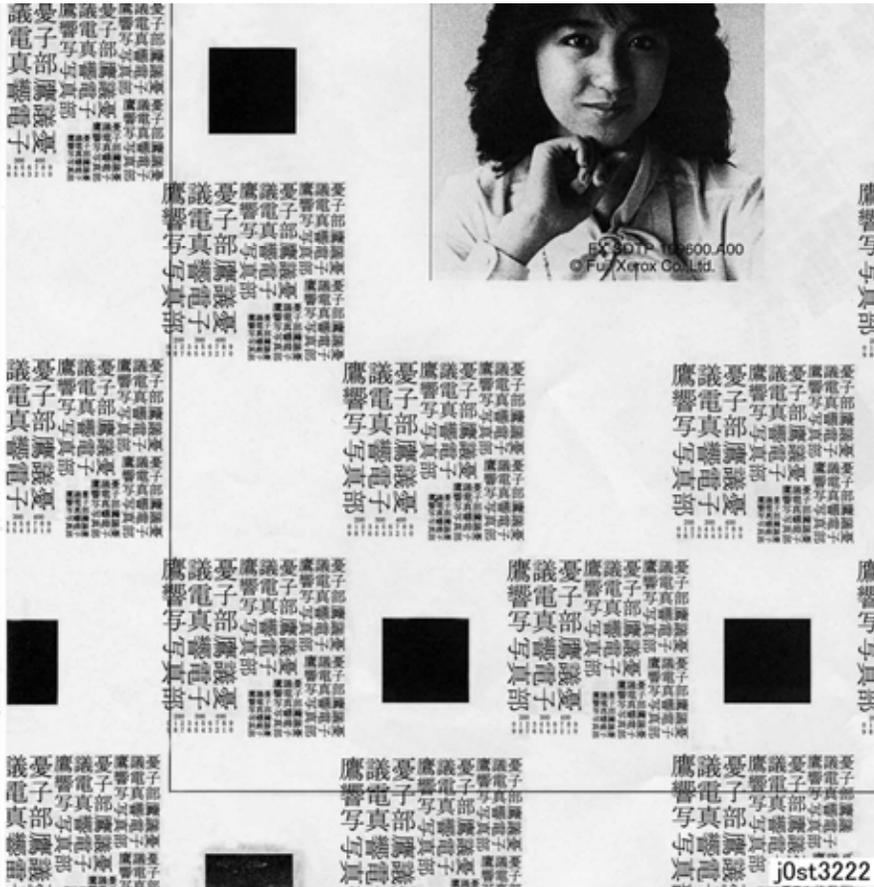
Figure 1 Toner Splattering Defect Sample)

1. Check the tray settings.
2. Use paper from a freshly opened packet.

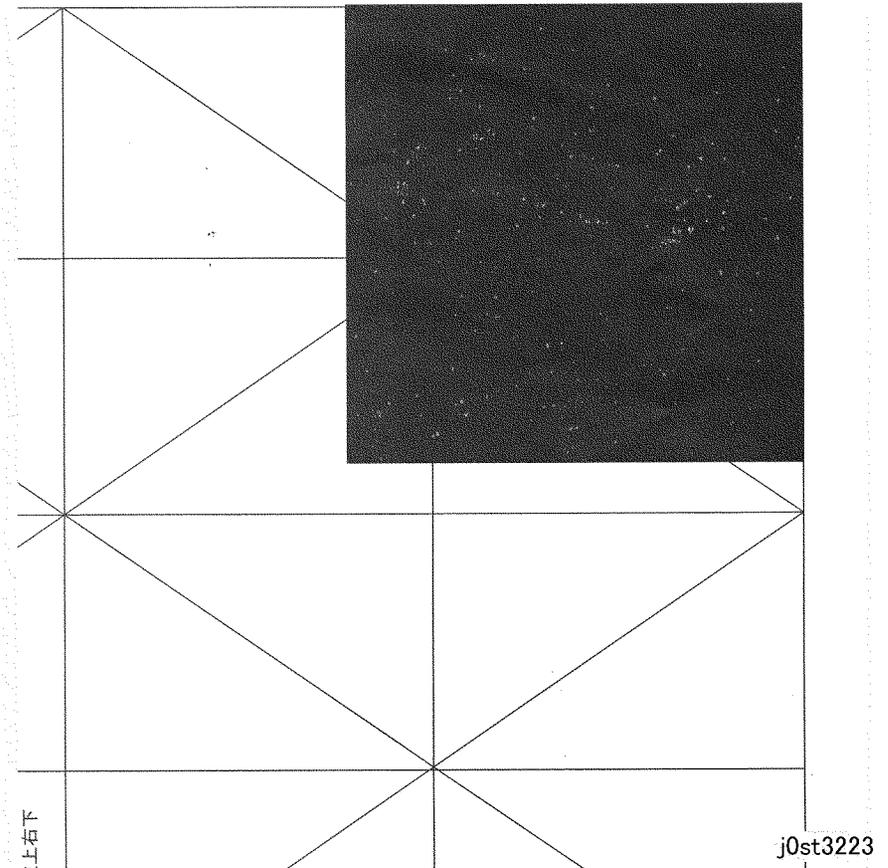
Figure 1 White Spots (Irregular) Defect Sample)

1. Use paper from a freshly opened packet.

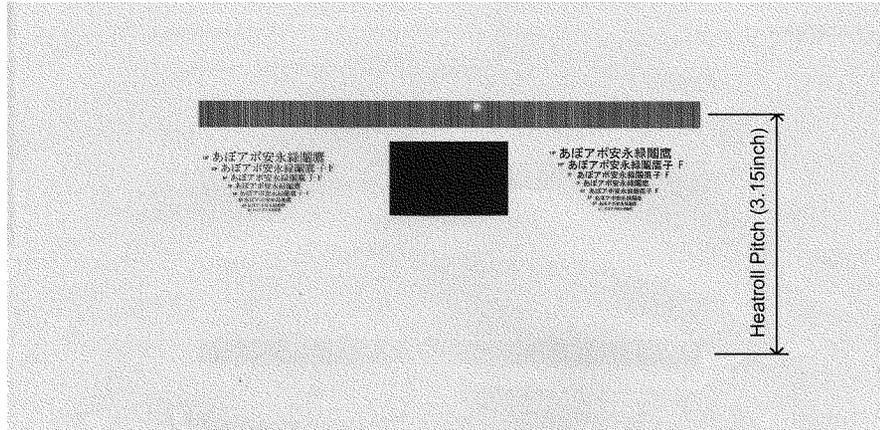
Figure 1 Transparency Offset (80mm Pitch Ghosts) Defect Sample

1. Select Transparency mode.

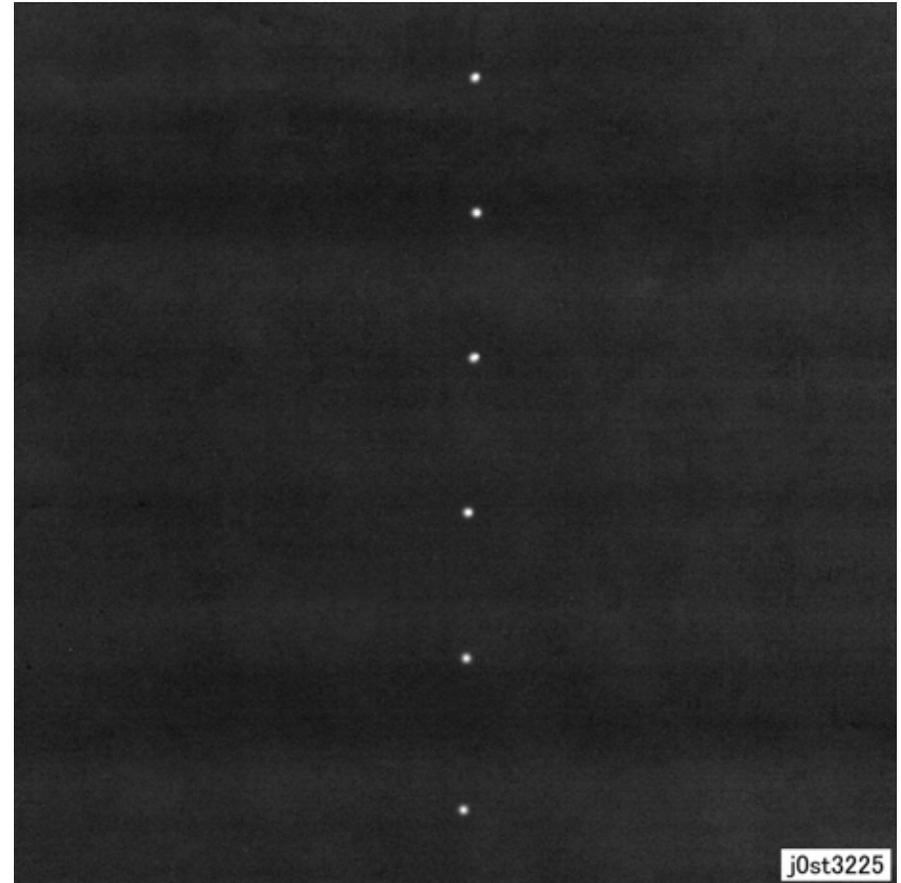
Figure 1 Regular Blanks In Process Direction (Spots, Streaks, Bands etc.) Defect Sample

1. 1, 4: Clean or replace the Xerographic Cartridge (PL 8.1) or the Fuser Unit (PL 7.1).
2. 2, 3: Replace the Xerographic Cartridge (PL 8.1).

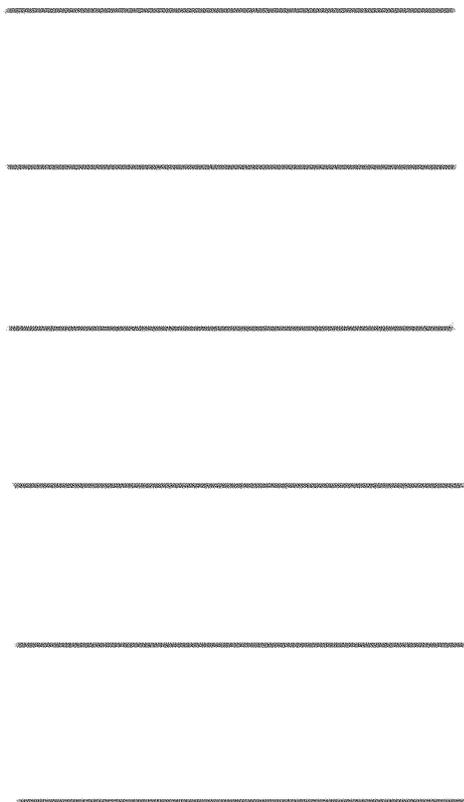
Figure 1 Regular Toner Contamination In Process Direction (Side 2) Defect Sample

1. 1, 2, 3: Clean or replace the relevant parts.
2. 2: Change the tray settings.

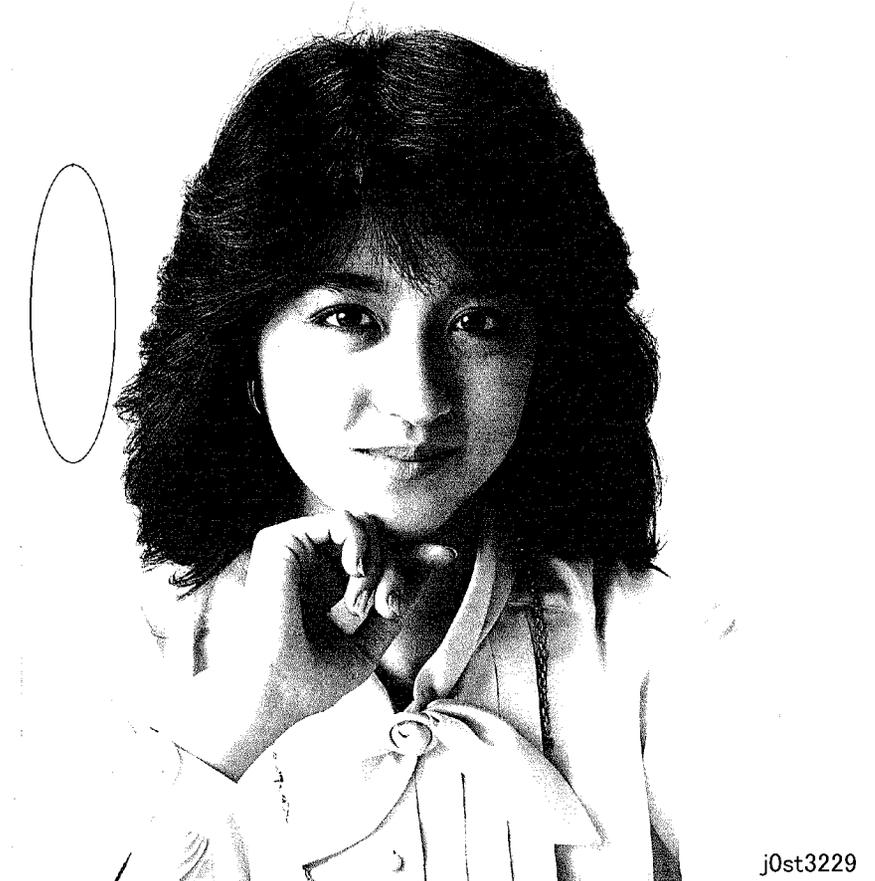
Figure 1 Light Background (in circled area for example) Due To Auto Exposure In Copies Of Originals With Frames Defect Sample

When Auto Exposure is turned [On] for originals with dark frames along the Lead Registration Edge, the suppression value is set so large such that areas of medium density appear extremely light.

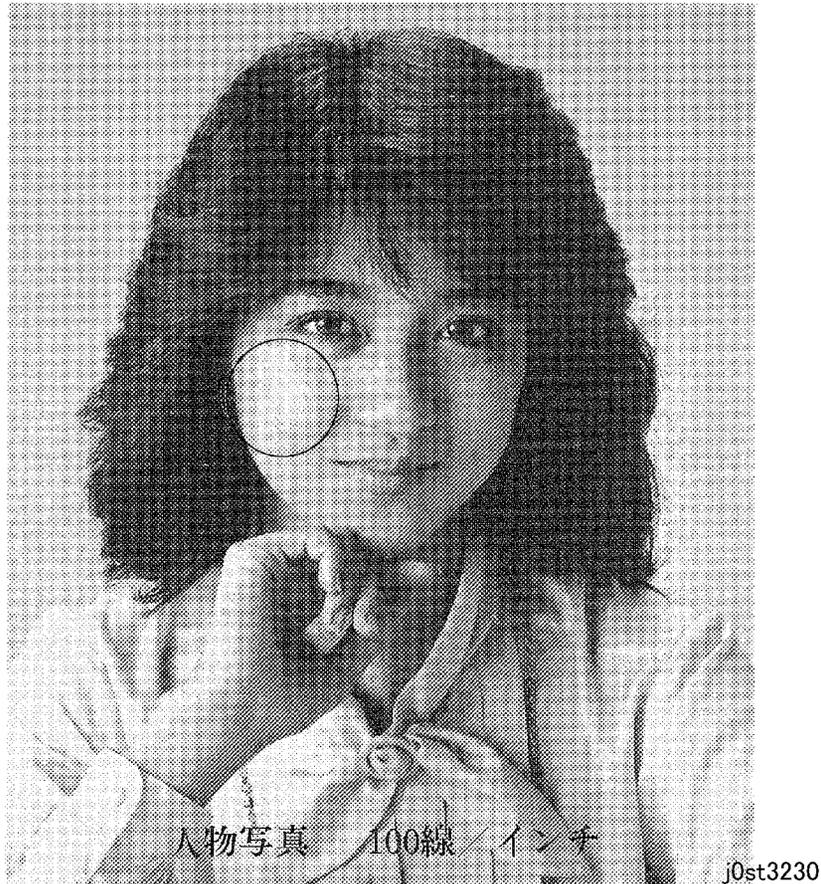
Figure 1 Gradation Jump In Text & Photo Mode For 100 Ipi Photo Originals Defect Sample

In Text mode, making copies of images of 100 lpi (halftone dot) gradation may result in a tone jump.

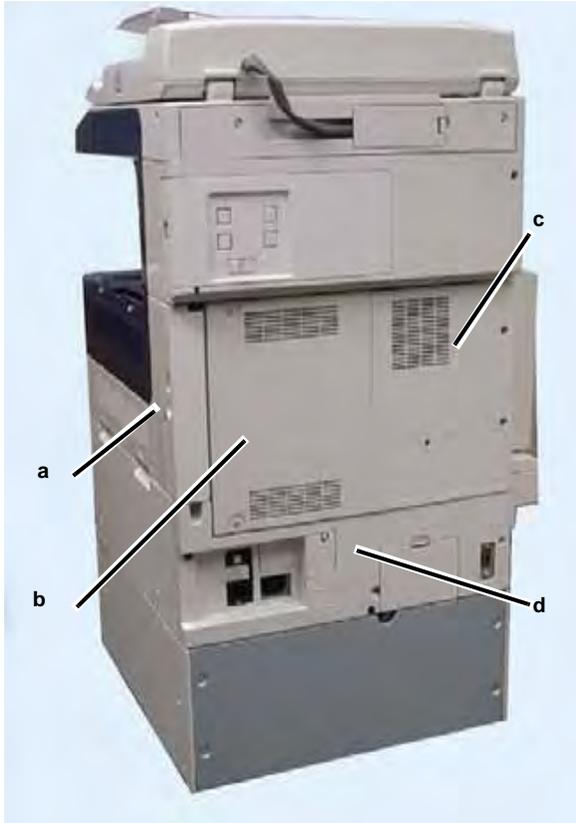
Figure 1 Removing Covers

1. Switch off the power and disconnect the power cord.
2. Remove the following covers ([Figure 1](#)).
 - a. Pull off the ESS Cap Cover.
 - b. ESS Cover (2 Screws).
 - c. Left Rear Middle Cover (2 Screws).
 - d. Rear Lower Cover (3 Screws).

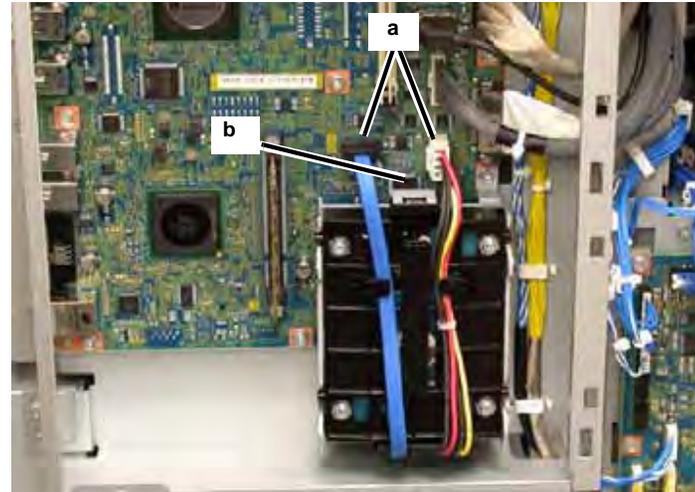
Figure 2 Removing HDD

3. Remove the HDD ([Figure 2](#)).
 - a. Disconnect the connectors (2).
 - b. Release the Locking Tab and remove the HDD.

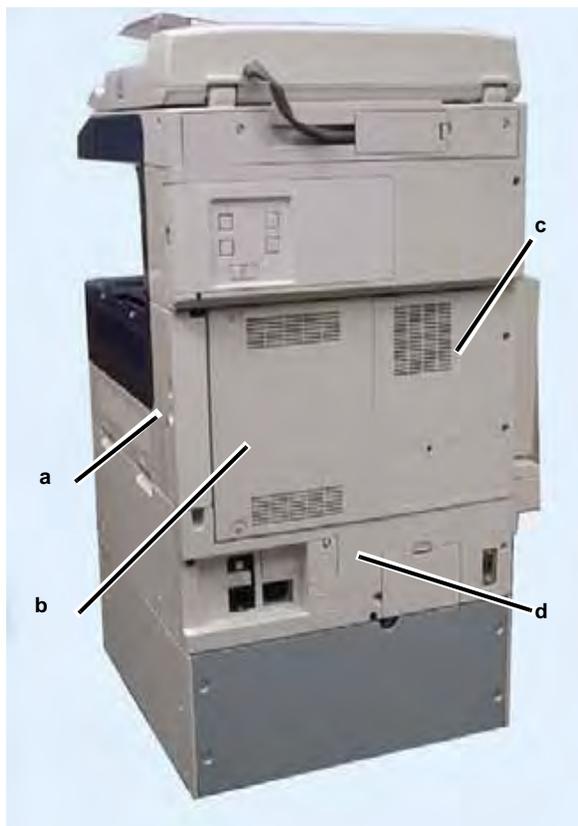
Figure 1 Removing Covers

1. Switch off the power and disconnect the power cord.
2. Remove the following covers (Figure 1).
 - a. Pull off the ESS Cap Cover.
 - b. ESS Cover (2 Screws).
 - c. Left Rear Middle Cover (2 Screws).
 - d. Rear Lower Cover (3 Screws).

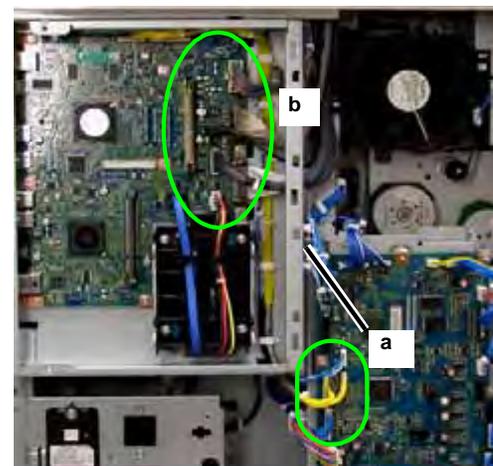
Figure 2 PWB PJ's

3. Perform the following (Figure 2).
 - a. Disconnect the MCU PWB connectors (3), and release the wires from the clamps on the ESS PWB panel.
 - b. Disconnect the ESS PWB connectors (5) and wire clamp (1). Then route the connectors and wire harness through the PWB panel openings.

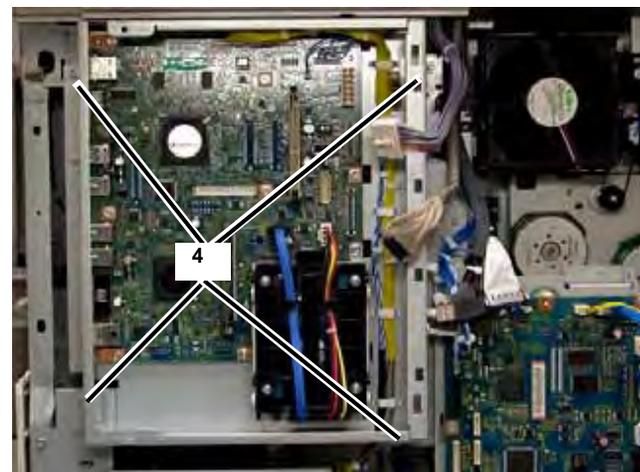
Figure 3 Removing Screws

4. Remove the ESS Chassis Assembly Screws (4), then lift up and remove (Figure 3).

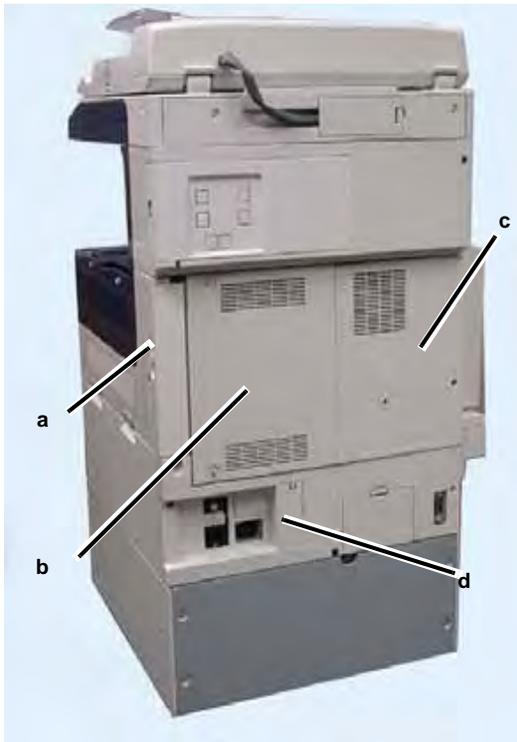
Figure 1 Removing Covers

1. Switch off the power and disconnect the power cord.
2. Remove the following covers (Figure 1).
 - a. Pull off the ESS Cap Cover.
 - b. ESS Cover (2 Screws).
 - c. Left Rear Middle Cover (2 Screws).
 - d. Rear Lower Cover (3 Screws).

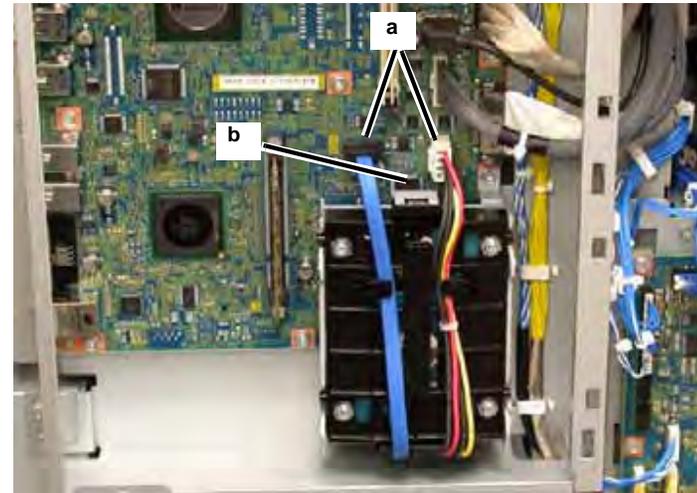
Figure 2 HDD

3. Remove the HDD (Figure 2).
 - a. Disconnect the connectors (2).
 - b. Release the Locking Tab and remove the HDD.

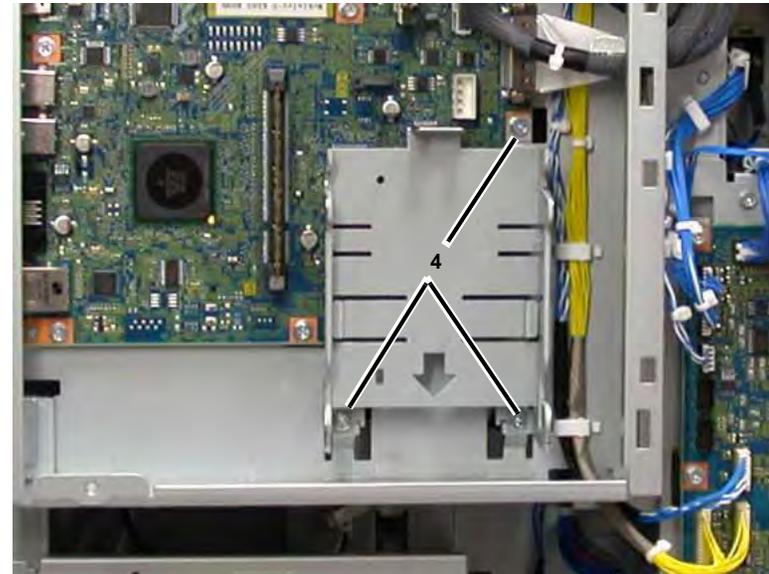
Figure 3 Bracket Screws

4. Remove the HDD Bracket (3 Screws) (Figure 3).
