WorkCentre 5335 Family Service Documentation

705P01303

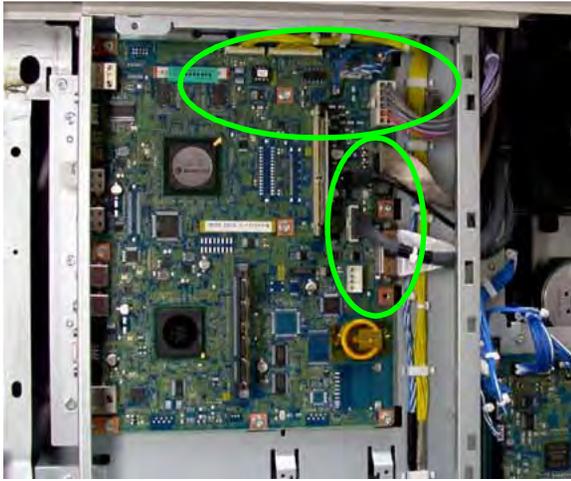
Figure 4 ESS PWB PJ's

5. Disconnect the ESS PWB connectors (9) (Figure 4).

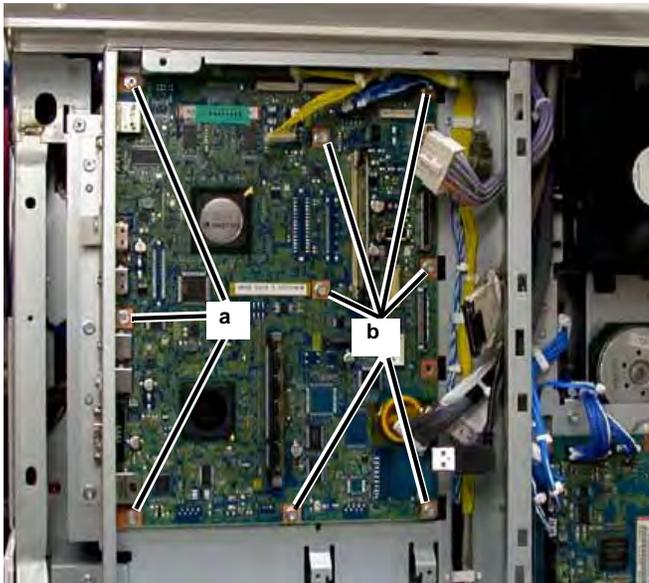
Figure 5 Removing Screws

6. Perform the following (Figure 5).
 - a. Remove the Screws (3) on the left side of the PWB.
 - b. Loosen the center and right side Screws (6).

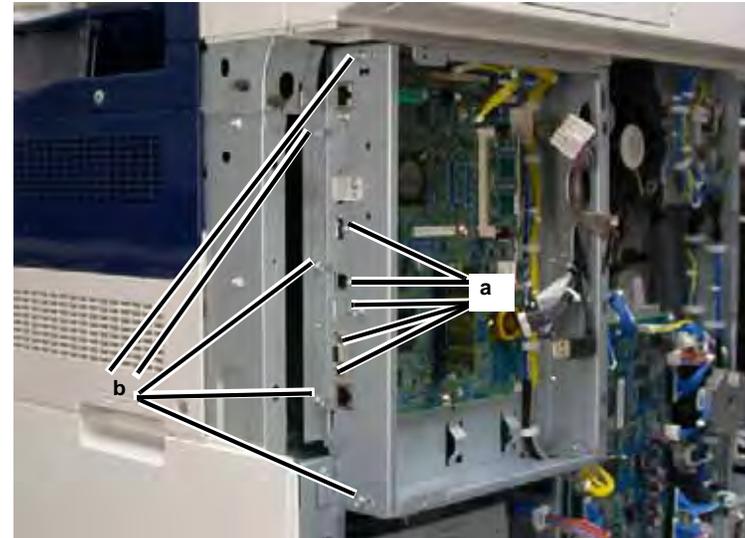
Figure 6 Removing Screws

7. Remove the left side of the PWB panel (Figure 6).
 - a. Remove the PWB connector Screws (5).
 - b. Remove the panel left side Screws (5).

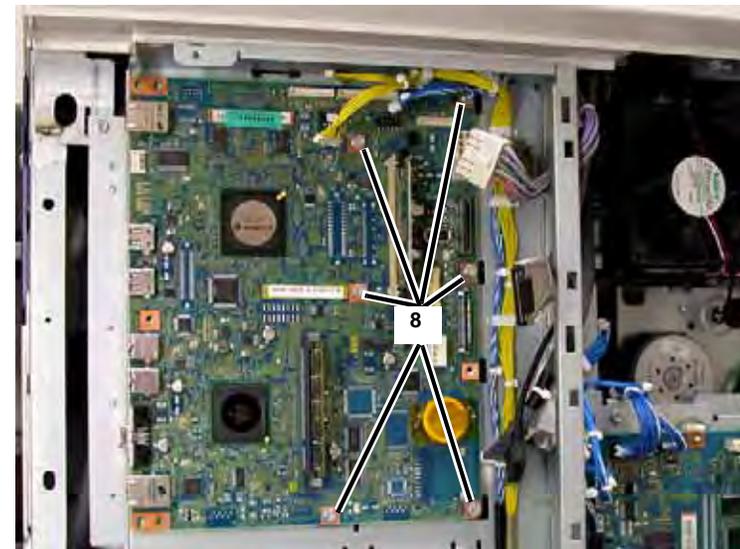
Figure 7 Removing Screws

8. Remove the ESS PWB (6 Screws) (Figure 7).

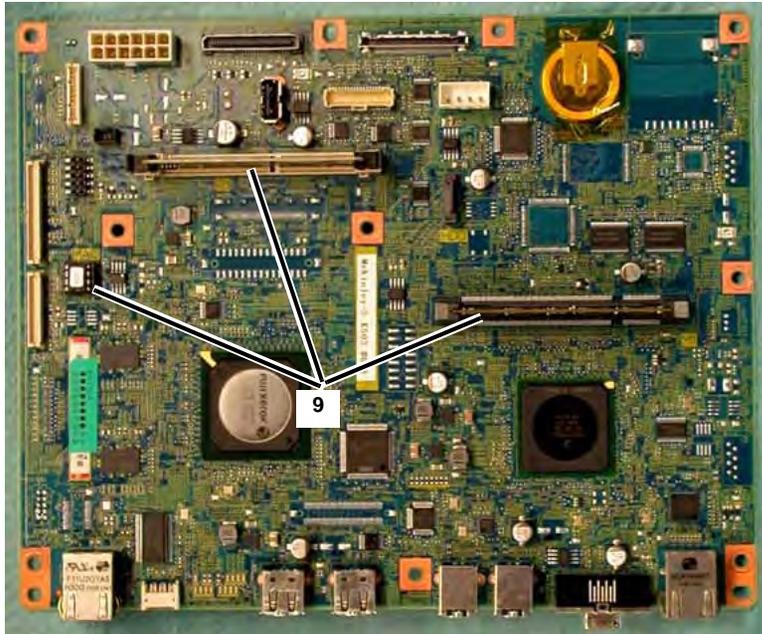
Figure 8 ESS PWB

Pin breakage occurs if the EPROM is carelessly removed.

9. When replacing the ESS PWB, remove the EPROM, the Memory PWB, and the Postscript PWB (if present, optional) (Figure 8).

A fatal error occurs to machine software if the ESS PWB is replaced before the EPROM is installed on the ESS PWB, and powered on.

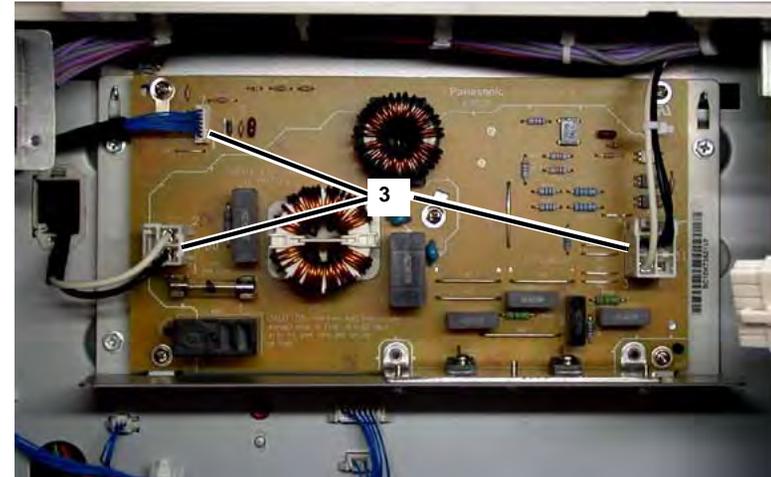
Figure 1 PJ's

1. Switch off the power and disconnect the power cord.
2. Remove the ESS Chassis [REP 3.2](#).
3. Disconnect the AC Driver PWB connectors (3) (Figure 1).

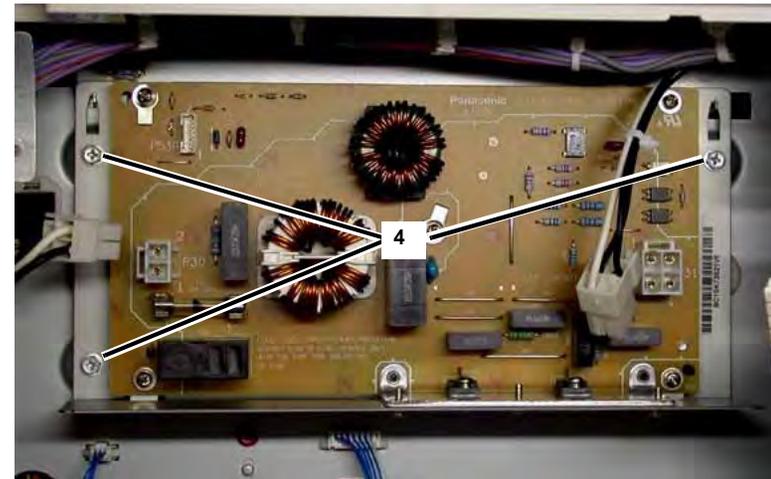
Figure 2 Removing Screws

4. Remove the AC Driver PWB and panel (3 Screws) (Figure 2).

NOTE: The AC Driver PWB screws (8) have a different thread than the other screws, keep them with the PWB for re-installation.

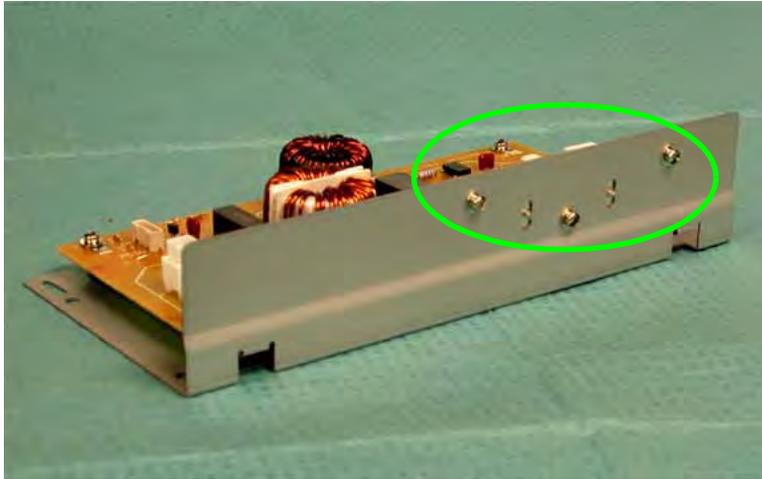
Figure 3 Removing Screws

5. Remove the screws (3) from the bottom of the panel (Figure 3).

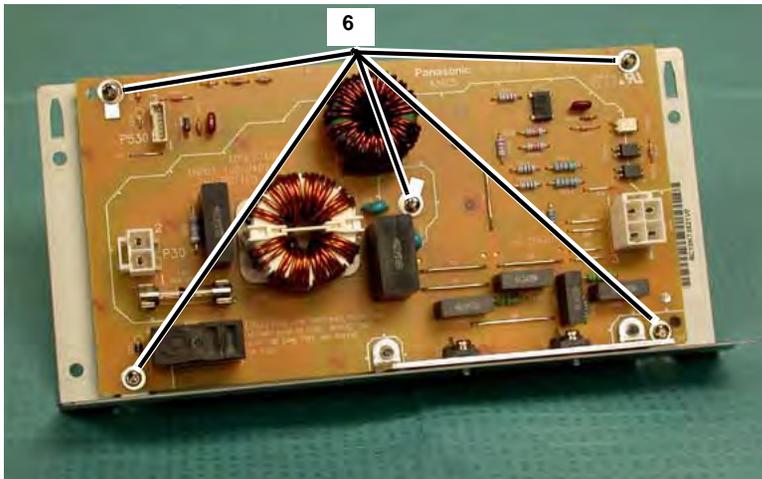
Figure 4 Removing Screws

6. Remove the AC Driver PWB screws (5) from the front of the panel (Figure 4).

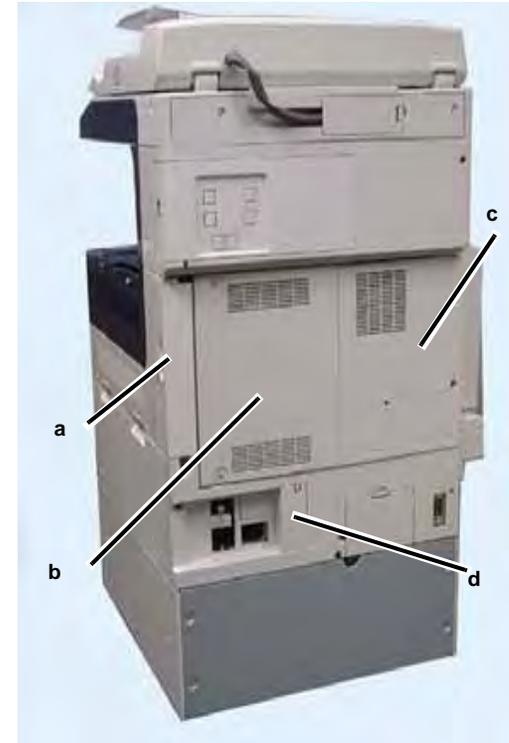
Figure 1 Removing Covers

1. Switch off the power and disconnect the power cord.
2. Remove the following covers (Figure 1).
 - a. Pull off the ESS Cap Cover.
 - b. ESS Cover (2 Screws).
 - c. Left Rear Middle Cover (2 Screws).
 - d. Rear Lower Cover (3 Screws).

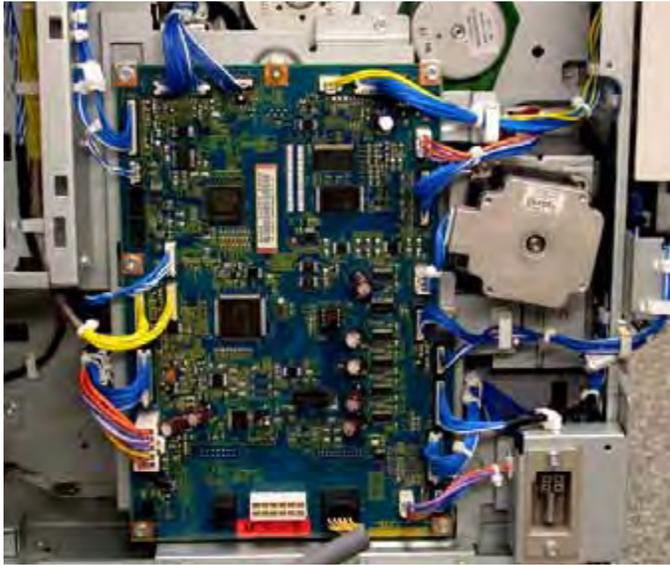
Figure 2 PJ's

3. Disconnect all the PJ's from the MCU PWB (Figure 2).

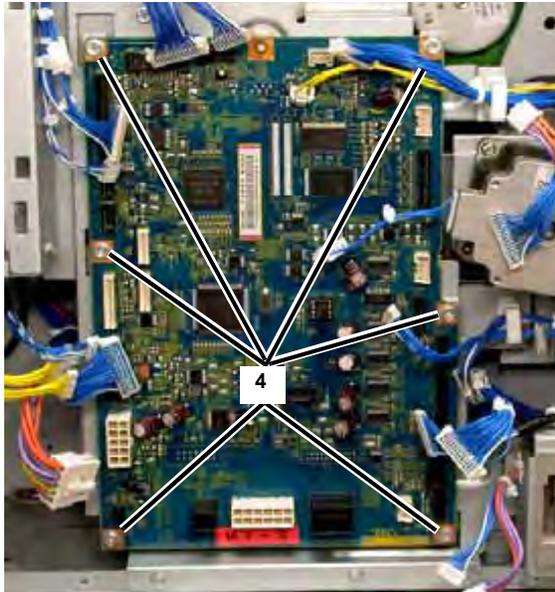
Figure 3 Removing Screws

4. Remove the Screws (6) and the MCU PWB (Figure 3).

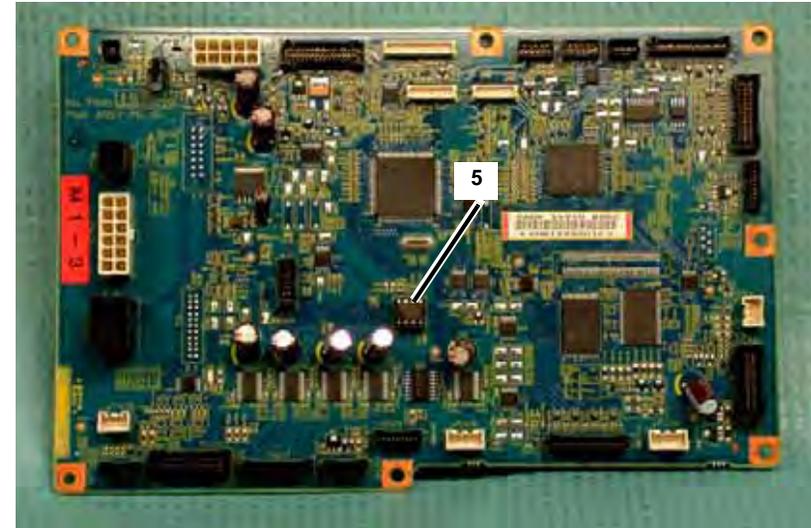
Figure 4 EEPROM

Pin breakage occurs if the EEPROM is carelessly removed.

5. When replacing the MCU PWB, remove the EEPROM from the old MCU PWB and install it onto the new MCU PWB (Figure 4).

A fatal error occurs to machine software if the MCU PWB is replaced before the EPROM is installed on MCU PWB, and powered on.

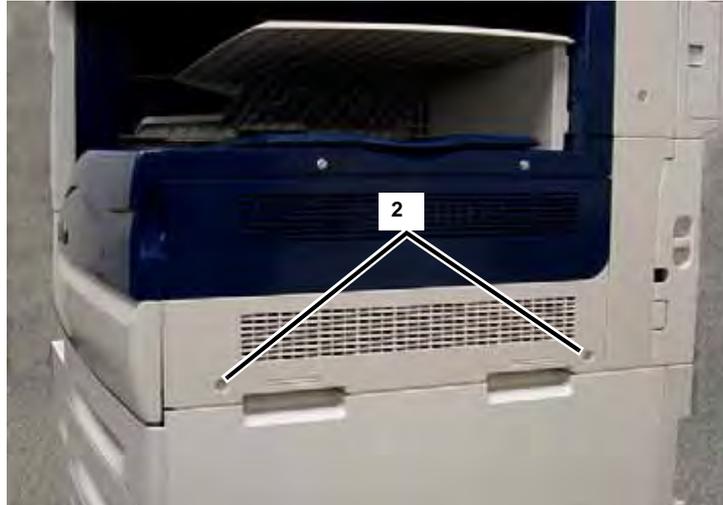
Figure 1 Removing Screws

1. Switch off the power and disconnect the power cord.
2. Remove the Right Cover 2 (2 Screws) ([Figure 1](#)).

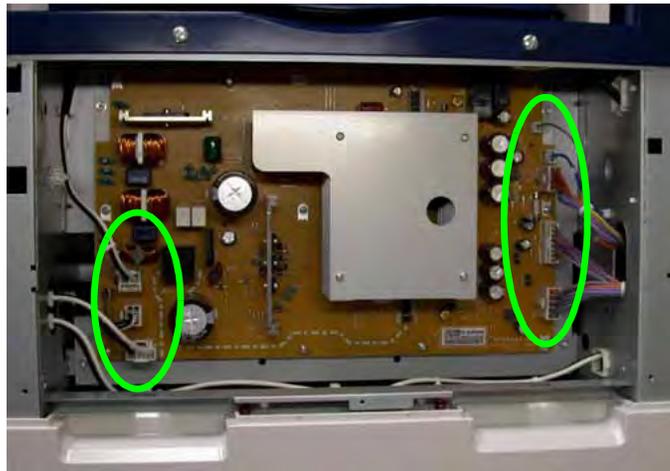
Figure 2 PJ's

3. Disconnect the Main LVPS connector (8) ([Figure 2](#)).

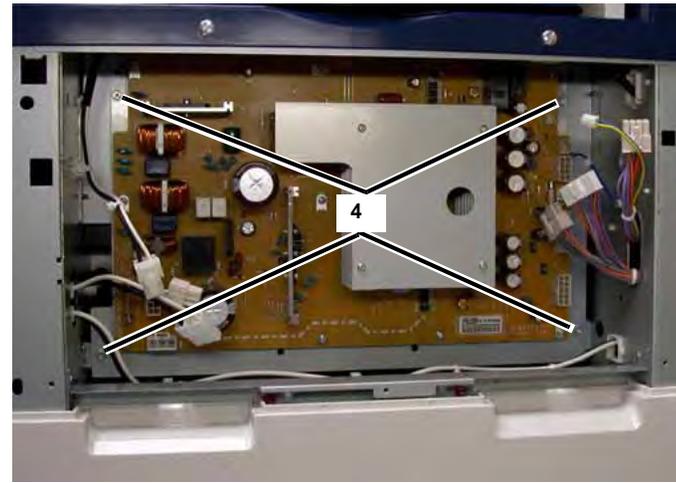
Figure 3 Removing Screws

4. Remove the Main LVPS and Chassis (4 Screws) ([Figure 3](#)).

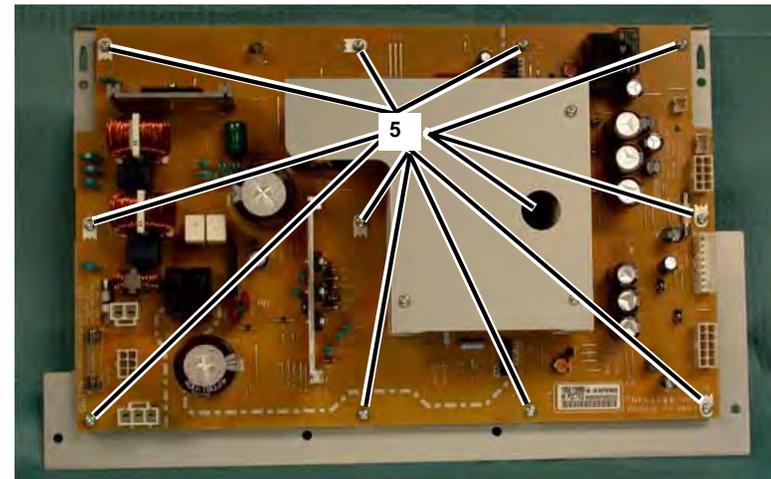
Figure 4 Removing Screws

5. Remove the Main LVPS (12 Screws) ([Figure 4](#)).

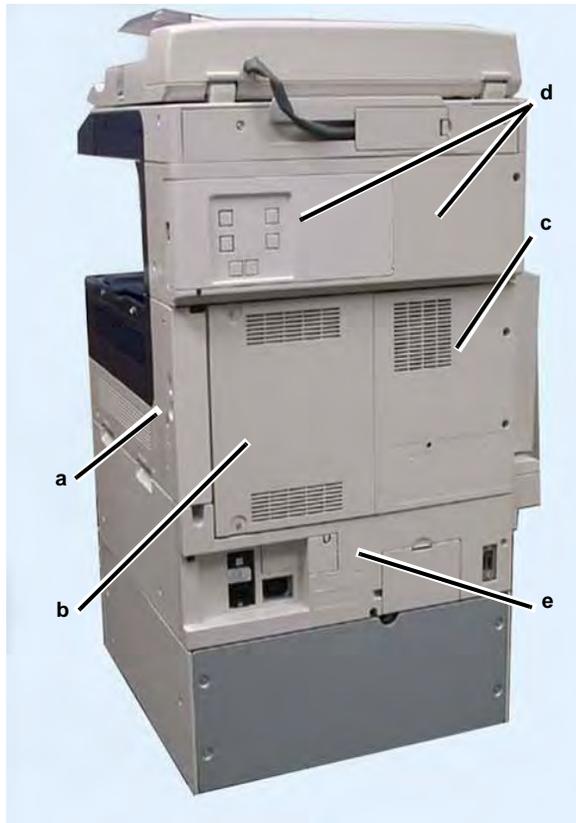
Figure 1 Removing Covers

1. Switch off the power and disconnect the power cord.
2. Remove the following covers (Figure 1).
 - a. Pull off the ESS Cap Cover.
 - b. ESS Cover (2 Screws).
 - c. Left Rear Middle Cover (2 Screws).
 - d. Fax Cover, and Rear Upper Cover (2 Screws).
 - e. Rear Lower Cover (3 Screws).

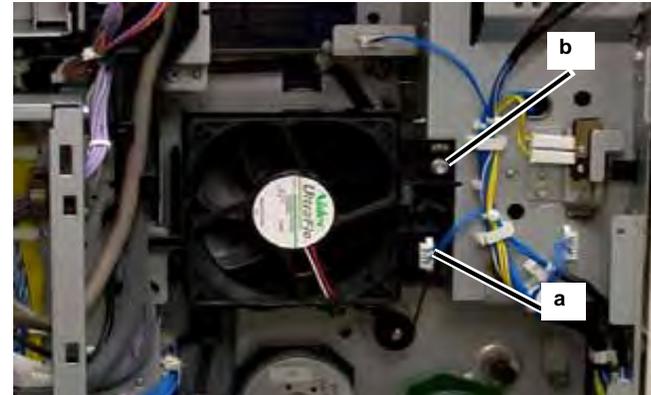
Figure 2 Fuser Exhaust Fan

3. Remove the Fuser Exhaust Fan Assembly (Figure 2).
 - a. Disconnect the connector.
 - b. Remove the Screw (1) and the fan assembly.

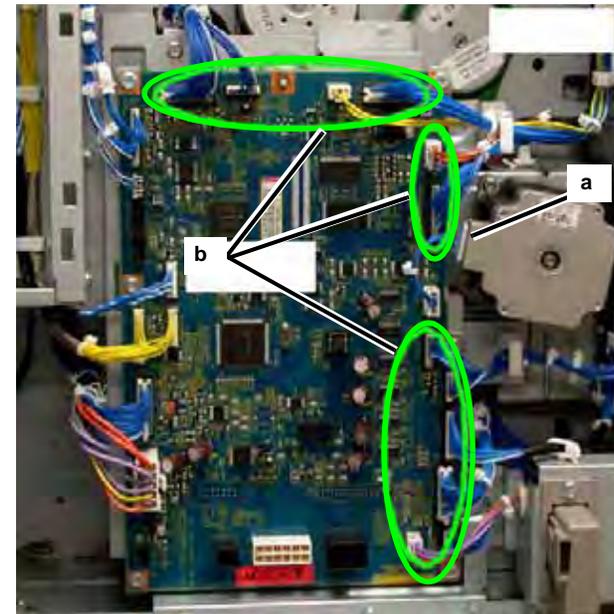
Figure 3 PJ's

4. Disconnect the following connectors (Figure 3).
 - a. Takeaway Motor connector.
 - b. MCU PWB top and right side connectors, and release the wires from the clamps.

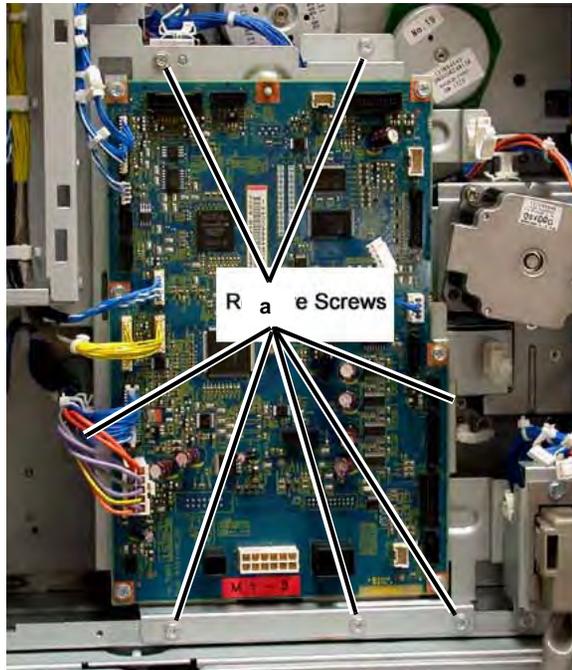
Figure 4 Removing Screws

5. Perform the following (Figure 4).
 - a. Remove the MCU PWB chassis Screws (7).
 - b. Move the MCU PWB chassis to the left.

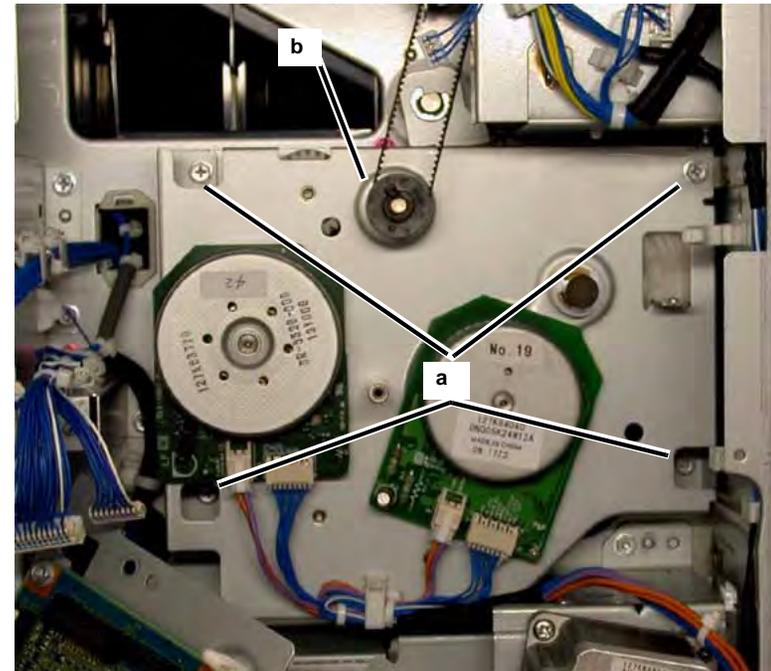
Figure 5 Removing Screws

Be careful not to damage any components on the motor PWB's when removing or replacing the Main Drive.

6. Remove the Main Drive (Figure 5).
 - a. Remove the Screws (4).
 - b. Lift the unit up to remove the drive belt from the pulley, then remove the Main Drive.

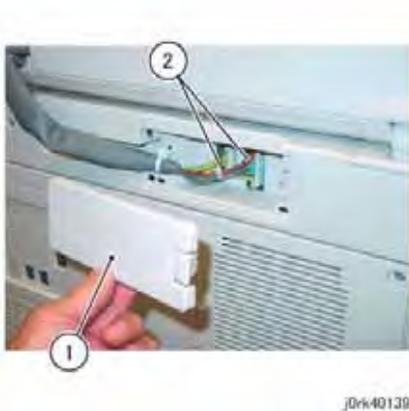
Figure 1 Connector

1. Switch off the power and disconnect the power cord.
2. Loosen the screws (x2) and disconnect the connector. (Figure 1)
 - (1) Disconnect the connector.

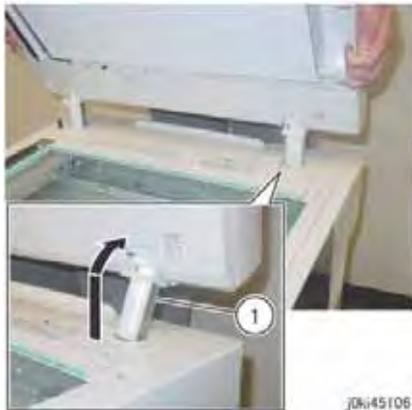
Figure 2 Tilt Counter Balance

3. Remove the DADF. (Figure 2)
 - (1) Tilt the Counter Balance in the direction of the arrow and remove it from the installation holes.

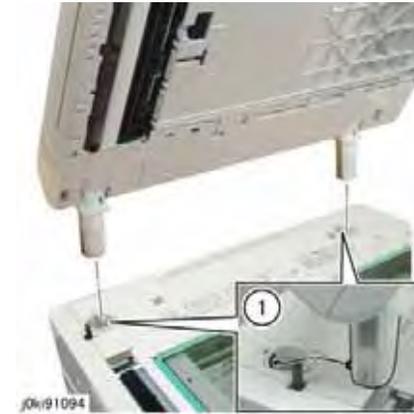
Figure 3 Inserting Tabs

2. Install the DADF. (Figure 3)
 - (1) Insert the tabs of the Counter Balance into the grooves of the installation holes.

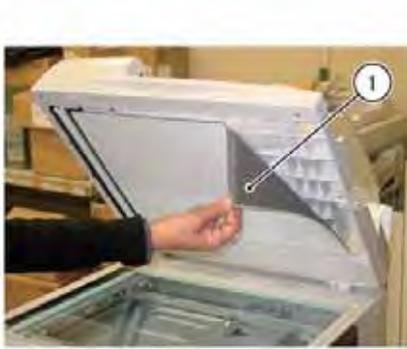
Figure 1 DADF Platen Cushion

NOTE: The DADF Platen Cushion is pasted on with double sided adhesive tapes.

1. Switch off the power and disconnect the power cord.
2. Peel off the DADF Platen Cushion. (Figure 1)
 - (1) Remove the DADF Platen Cushion.

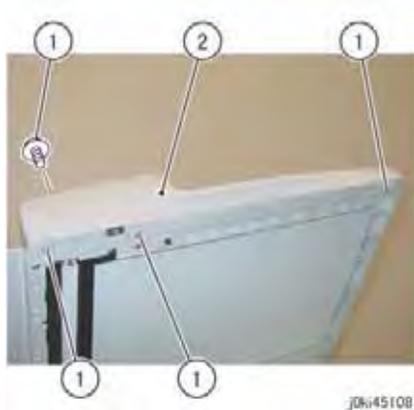
Figure 1 DADF Front Cover Removal

1. Switch off the power and disconnect the power cord.
2. Open the Top Cover.
3. Open the DADF.
4. Remove the DADF Front Cover. ([Figure 1](#))
 - (1) Remove the self-self-tapping screws (x4).
 - (2) Remove the DADF Front Cover.

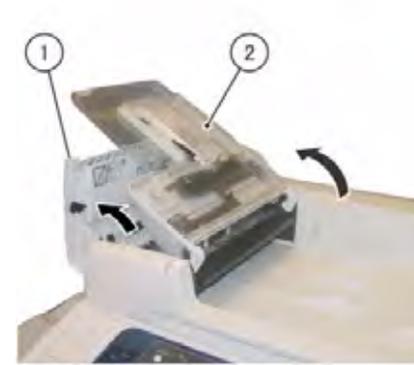
Figure 1 DADF Upside Down

1. Switch off the power and disconnect the power cord.
2. Turn the DADF Document Tray upside down. ([Figure 1](#))
 - (1) Open the Top Cover.
 - (2) Turn the DADF Document Tray upside down.

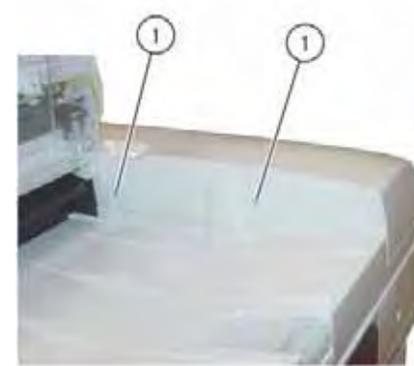
Figure 2 DADF Rear Cover

3. Remove the screws that secure the DADF Rear Cover. ([Figure 2](#))
 - (1) Remove the screws (x2).

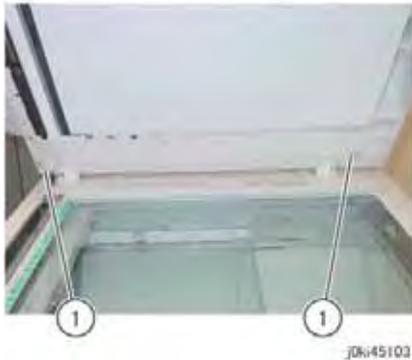
Figure 3 Releasing Hooks

4. Open the DADF.
5. Release the hooks of the DADF Rear Cover. ([Figure 3](#))

(1) Release the hooks (x2).

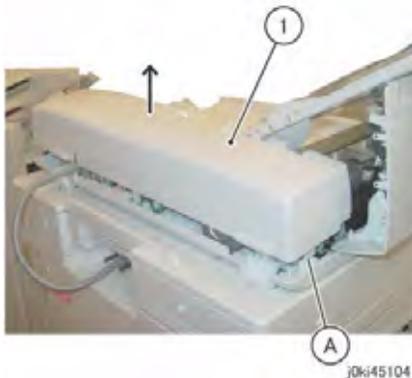
Figure 4 Removing DADF Rear Cover

6. Close the DADF gently.
7. Remove the DADF Rear Cover. (Figure 4)
 - (1) Remove the DADF Rear Cover in the direction of the arrow.
 - (A) Hook

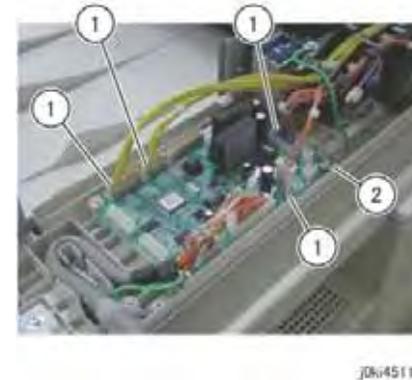
Figure 1 DADF Connectors

1. Switch off the power and disconnect the power cord.
2. Remove the DADF Front Cover. (REP 5.3)
3. Remove the DADF Rear Cover. (REP 5.4)
4. Remove the DADF. (REP 5.1)
5. Remove the DADF Document Tray. (REP 5.9)
6. Disconnect the DADF PWB connectors. (Figure 1)
 - (1) Disconnect the connectors (x4).
 - (2) Remove the self-tapping screw and the Ground Wire.

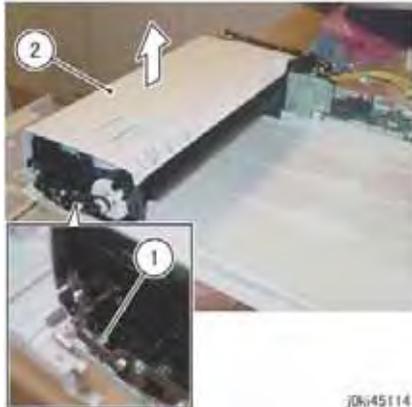
Figure 2 DADF Feeder Assembly Removal

7. Remove the DADF Feeder Assembly. (Figure 2)
 - (1) Remove the self-tapping screw.
 - (2) Remove the DADF Feeder Assembly in the direction of the arrow.

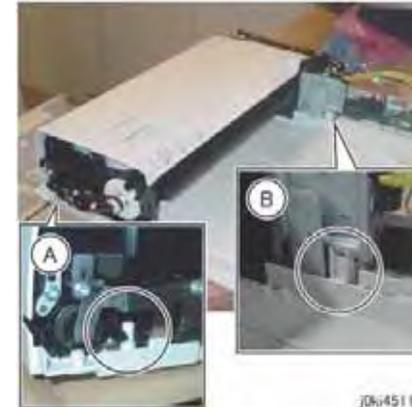
Figure 4 Installing the Feeder Assembly to the Base Frame

3. When installing the Feeder Assembly to the Base Frame, check the following (Figure 4)
 - (A) At the front: The Frame of the DADF Feeder Assembly is attached to the positioning pin of the Base Frame as shown in the figure.
 - (B) The Bracket of the DADF Feeder Assembly is attached to the support of the Base Frame as shown in the figure.

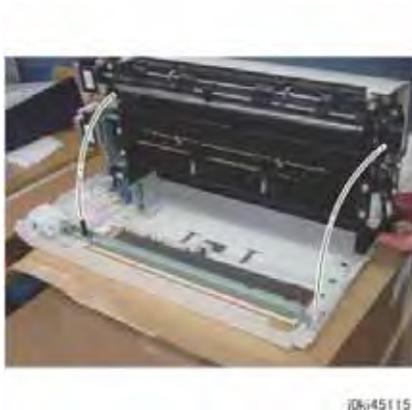
Figure 3 Align the Positioning Pin

1. To install, carry out the removal steps in reverse order.
2. Align the positioning pin of the Base Frame and the hole of the DADF Feeder Assembly. (Figure 3)

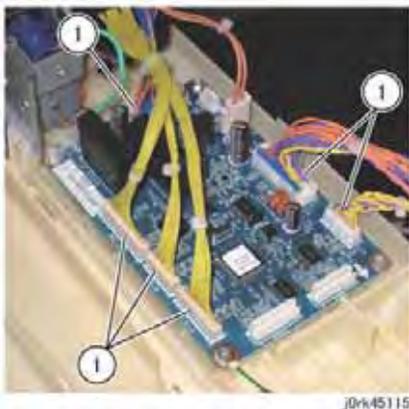
Figure 1 DADF PWB Connectors

1. Switch off the power and disconnect the power cord.
2. Remove the DADF Rear Cover. (REP 5.4)
3. Disconnect the DADF PWB connectors. (Figure 1)
 - (1) Disconnect the connectors (x6).

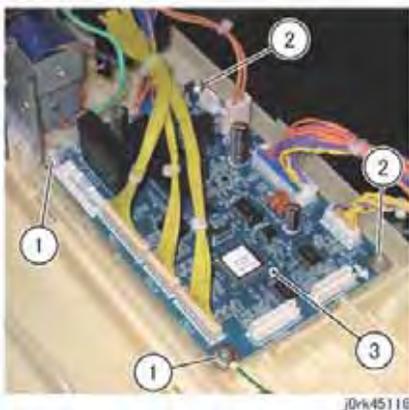
Figure 2 DADF PWB Removal

4. Remove the DADF PWB. (Figure 2)
 - (1) Remove the self-tapping screws (x2) and the Ground Wires (x2).
 - (2) Remove the self-tapping screws (x2).
 - (3) Remove the DADF PWB.

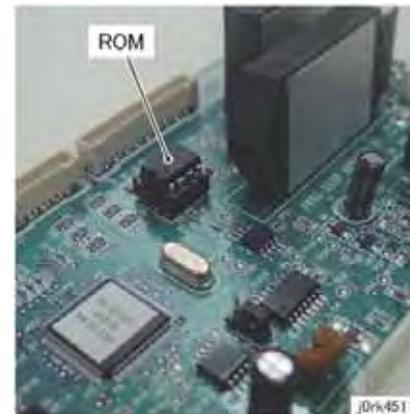
Figure 3 ROM

1. To install, carry out the removal steps in reverse order.
2. Switch the ROM on the new PWB with the EEPROM from the old PWB. (Figure 3)
This is because it stores the alignment value of the DADF.

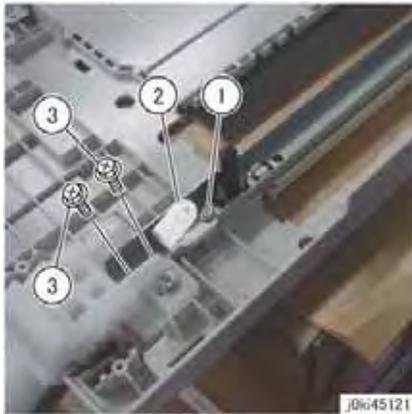
Figure 1 Tie Plate Screws

- *Left Counter Balance: strong spring pressure*
 - *Right Counter Balance: weak spring pressure*
1. Switch off the power and disconnect the power cord.
 2. Remove the DADF Front Cover. (REP 5.3)
 3. Remove the DADF Rear Cover. (REP 5.4)
 4. Remove the DADF. (REP 5.1)
 5. Remove the DADF Document Tray. (REP 5.9)
 6. Remove the DADF Feeder Assembly. (REP 5.5)
 7. Remove the screws that secure the Tie Plate. (Figure 1)
 - (1) Remove the self-tapping screw.
 - (2) Remove the Ground Plate.
 - (3) Remove the self-tapping screws (x2).

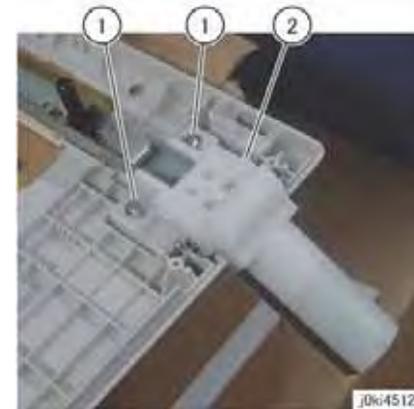
Figure 2 Left Counter Balance

8. Remove the Left Counter Balance. (Figure 2)
 - (1) Remove the self-tapping screws (Large: x2).
 - (2) Remove the Left Counter Balance.

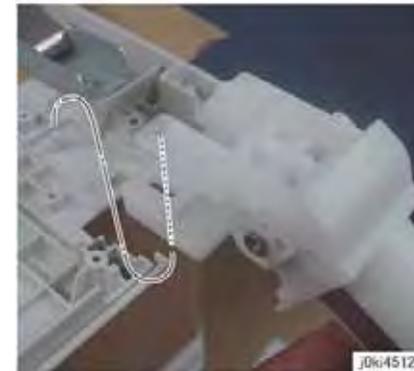
Figure 3 Left Counter Balance Hole Alignment

1. To install, carry out the removal steps in reverse order.
2. When installing the Left Counter Balance, align the hole of the Left Counter Balance to the positioning boss of the Frame. (Figure 3)

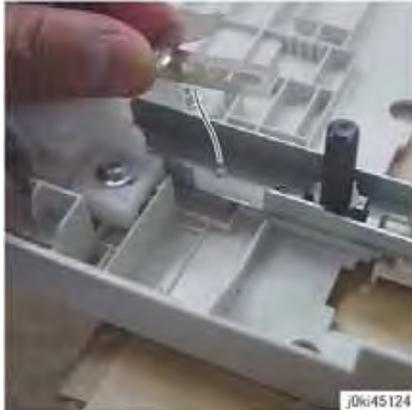
Figure 4 Ground Plate Alignment

3. Align the Ground Plate to the positioning boss. (Figure 4)

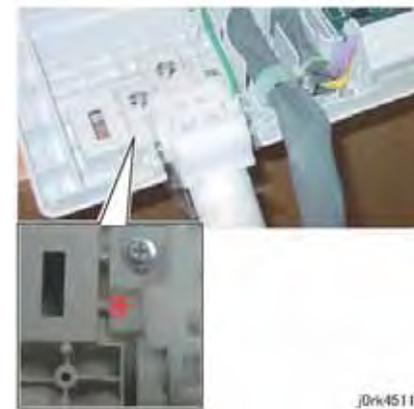
Figure 1 Graduation Scale Marks

- *Left Counter Balance: strong spring pressure*
 - *Right Counter Balance: weak spring pressure*
1. Switch off the power and disconnect the power cord.
 2. Remove the DADF Rear Cover. ([REP 5.4](#))
 3. Remove the DADF. ([REP 5.1](#))
 4. Take note of the graduation of the scale. ([Figure 1](#))

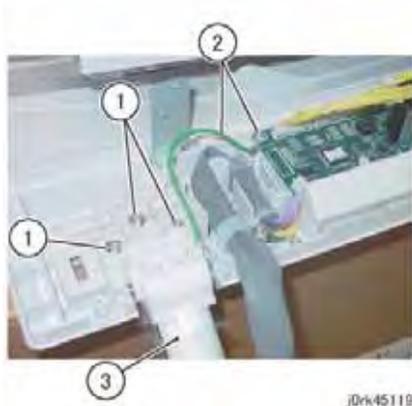
Figure 2 Right Counter Balance Removal

5. Remove the Right Counter Balance. ([Figure 2](#))
 - (1) Remove the self-tapping screws (Large: x3).
 - (2) Remove the screw (Small: x1) and remove the Ground Wire.
 - (3) Remove the right Counter Balance.

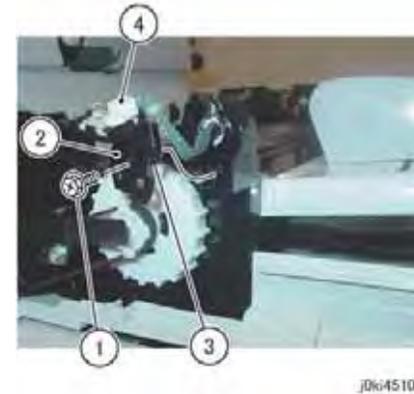
Figure 1 DADF Set LED Connector

1. Switch off the power and disconnect the power cord.
2. Remove the DADF Front Cover. (REP 5.3)
3. Remove the DADF Rear Cover. (REP 5.4)
4. Disconnect the connector of the DADF Document Set LED. (Figure 1)
 - (1) Remove the self-tapping screw.
 - (2) Remove the LED Bracket.
 - (3) Remove the wire harness from the hook.
 - (4) Disconnect the connector.

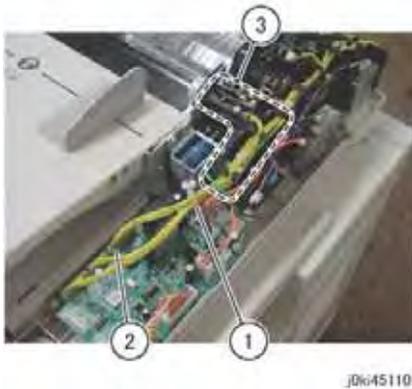
Figure 2 DADF Set LED Connector Removal

5. Disconnect the connector. (Figure 2)
 - (1) Remove the clamp.
 - (2) Disconnect the connector of the P/J756.
 - (3) Remove the P/J756 wire harness from the Harness Guide.

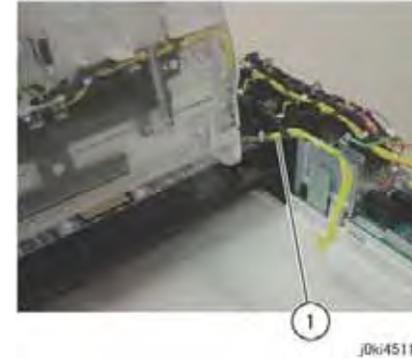
Figure 4 Wire Harness Removal

7. Pull out and remove the wire harness at the rear side of the DADF Document Tray from the hole of the Frame. (Figure 4)
 - (1) Pull out and remove the wire harness through the hole on the Frame.

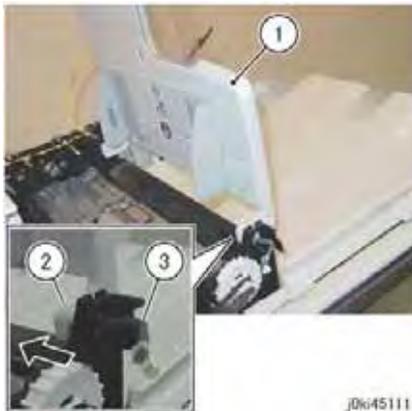
Figure 3 Boss Removal

6. At the front side of the DADF Document Tray, remove the boss of the DADF Document Tray from the installation hole of the Frame. (Figure 3)
 - (1) Position the DADF Document Tray vertically.
 - (2) Press the boss of the DADF Document Tray in the direction of the arrow and remove it from the installation hole.
 - (3) Remove the wire harness of the DADF Document Set LED from the groove of the Frame.

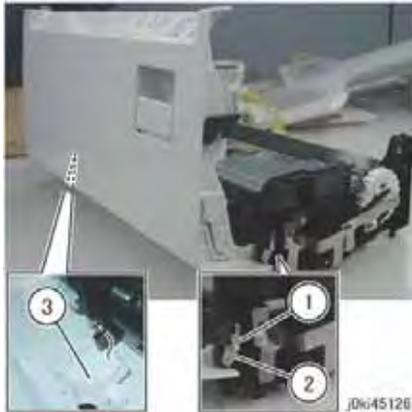
Figure 1 Top Cover Removal

1. Switch off the power and disconnect the power cord.
2. Remove the DADF Front Cover. ([REP 5.3](#))
3. Remove the DADF Rear Cover. ([REP 5.4](#))
4. Remove the DADF. ([REP 5.1](#))
5. Remove the DADF Document Tray. ([REP 5.9](#))
6. Remove the DADF Feeder Assembly. ([REP 5.5](#))
7. Remove the Registration Chute. ([REP 5.14](#))
8. Open the Top Cover.
9. Remove the Top Cover. ([Figure 1](#))
 - (1) Remove the self-tapping screw.
 - (2) Remove the Stud Bracket.
 - (3) Remove the Top Cover.

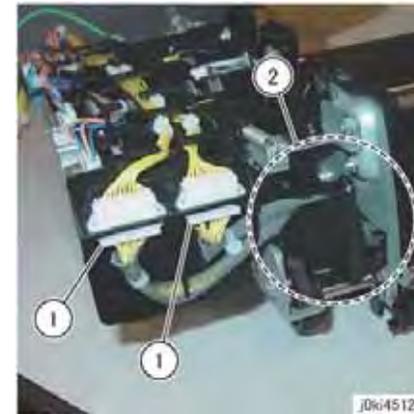
Figure 1 Wire Harness Removal

1. Switch off the power and disconnect the power cord.
2. Remove the DADF Front Cover. ([REP 5.3](#))
3. Remove the DADF Rear Cover. ([REP 5.4](#))
4. Remove the DADF. ([REP 5.1](#))
5. Remove the DADF Document Tray. ([REP 5.9](#))
6. Remove the DADF Feeder Assembly. ([REP 5.5](#))
7. Remove the Registration Chute. ([REP 5.14](#))
8. Remove the Top Cover. ([REP 5.10](#))
9. Remove the wire harness from the Harness Guide. ([Figure 1](#))
 - (1) Disconnect the connectors (x2).
 - (2) Remove the wire harness from the Harness Guide.

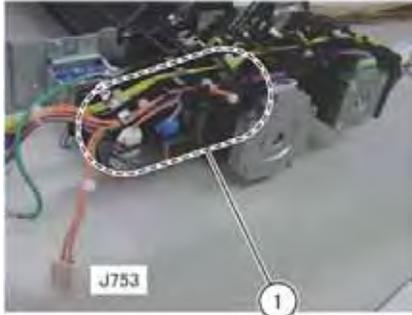
Figure 2 J753 Location

10. Remove the wire harness from the Harness Guide. ([Figure 2](#))
 - (1) Remove the J753 wire harness from the Harness Guide.

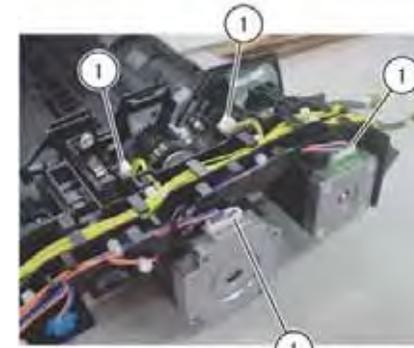
Figure 4 Harness Connectors

12. Disconnect the connector. (Figure 4)
 - (1) Disconnect the connectors (x4).

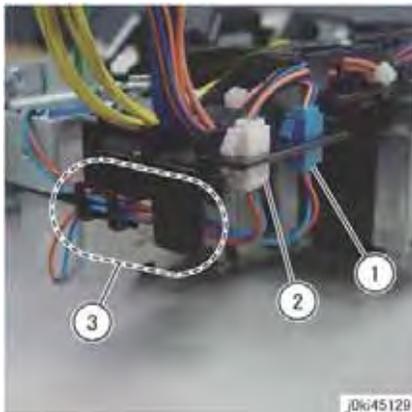
Figure 3 Solenoid Harness Removal

11. Remove the wire harness of the solenoid from the Harness Guide. (Figure 3)
 - (1) Disconnect the connector (Blue).
 - (2) Disconnect the connector (White).
 - (3) Remove the wire harness from the Harness Guide.

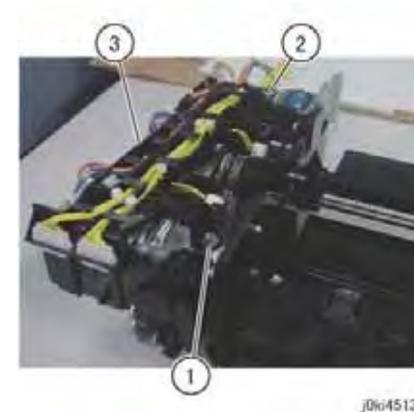
Figure 5 Harness Removal

13. Remove the Harness Guide and the wire harness. (Figure 5)
 - (1) Remove the screw.
 - (2) Remove the screw and the Ground Wire.
 - (3) Remove the Harness Guide and the wire harness.

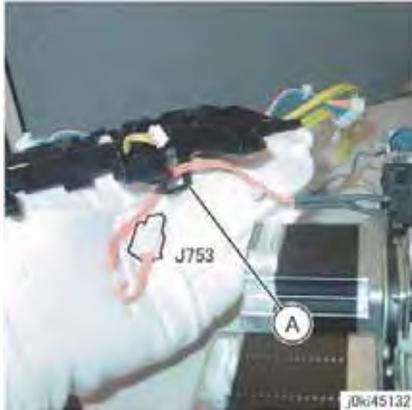
Figure 6 J753 Harness Hook

1. To install, carry out the removal steps in reverse order.
2. Hang the J753 wire harness to the hook (A). (Figure 6) (A)Hook

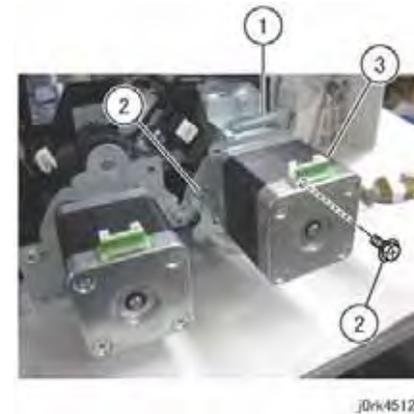
Figure 1 DADF Reg Motor

1. Switch off the power and disconnect the power cord.
2. Remove the DADF Front Cover. ([REP 5.3](#))
3. Remove the DADF Rear Cover. ([REP 5.4](#))
4. Remove the DADF. ([REP 5.1](#))
5. Remove the DADF Document Tray. ([REP 5.9](#))
6. Remove the DADF Feeder Assembly. ([REP 5.5](#))
7. Remove the Registration Chute. ([REP 5.14](#))
8. Remove the Top Cover. ([REP 5.10](#))
9. Remove the Harness Guide and the wire harness. ([REP 5.11](#))
10. Remove the DADF Registration Motor. ([Figure 1](#))
 - (1) Remove the spring.
 - (2) Remove the screws (x2).
 - (3) Remove the DADF Registration Motor.

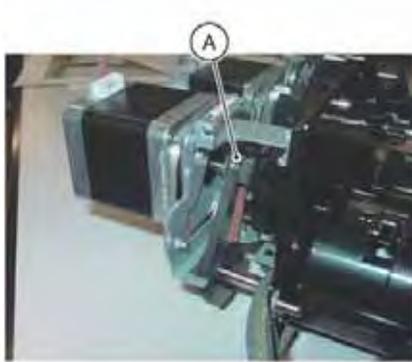
J0rk45135

Figure 2 Belt Installation

1. To install, carry out the removal steps in reverse order.
2. Install the Belt (A) to the Pulley of the DADF Registration Motor. ([Figure 2](#))
(A)Belt

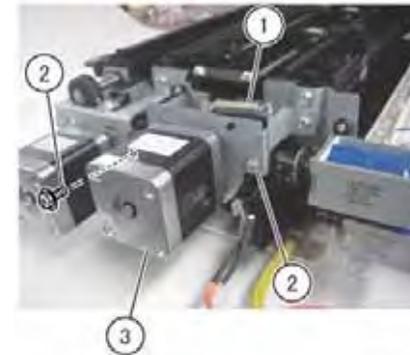
J0rk45122

Figure 1 DADF Feed Motor Removal

1. Switch off the power and disconnect the power cord.
2. Remove the DADF Front Cover. ([REP 5.3](#))
3. Remove the DADF Rear Cover. ([REP 5.4](#))
4. Remove the DADF. ([REP 5.1](#))
5. Remove the DADF Document Tray. ([REP 5.9](#))
6. Remove the DADF Feeder Assembly. ([REP 5.5](#))
7. Remove the Registration Chute. ([REP 5.14](#))
8. Remove the Top Cover. ([REP 5.10](#))
9. Remove the Harness Guide and the wire harness. ([REP 5.11](#))
10. Turn the DADF Feeder Assembly upside down.
11. Remove the DADF Feed Motor. ([Figure 1](#))
 - (1) Remove the spring.
 - (2) Remove the screws (x2).
 - (3) Remove the DADF Feed Motor.

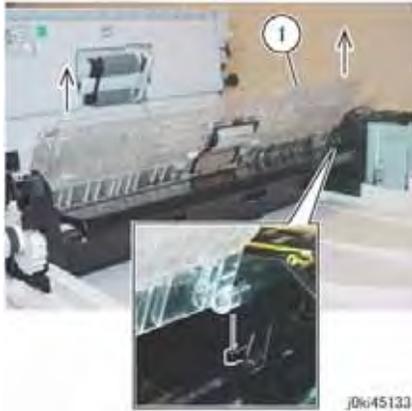
Figure 1 Retard Chute

1. Switch off the power and disconnect the power cord.
2. Remove the DADF Front Cover. ([REP 5.3](#))
3. Remove the DADF Rear Cover. ([REP 5.4](#))
4. Remove the DADF Document Tray. ([REP 5.9](#))
5. Open the Retard Chute.
6. Remove the Retard Chute. ([Figure 1](#))
 - a. Remove the Retard Chute in the direction of the arrow.

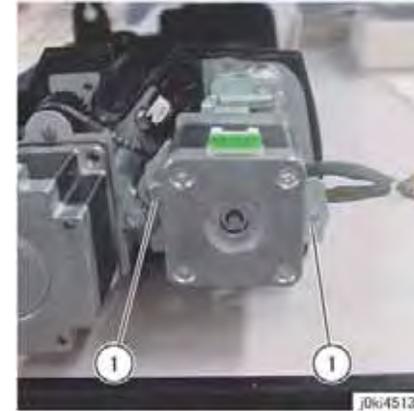
Figure 1 DADF Reg Motor Belt Tension

1. Switch off the power and disconnect the power cord.
2. Remove the DADF Front Cover. ([REP 5.3](#))
3. Remove the DADF Rear Cover. ([REP 5.4](#))
4. Remove the DADF. ([REP 5.1](#))
5. Remove the DADF Document Tray. ([REP 5.9](#))
6. Remove the DADF Feeder Assembly. ([REP 5.5](#))
7. Remove the Registration Chute. ([REP 5.14](#))
8. Remove the Top Cover. ([REP 5.10](#))
9. Remove the Harness Guide and the wire harness. ([REP 5.11](#))
10. Loosen the Belt tension of the DADF Registration Motor. ([Figure 1](#))
 - (1) Loosen the screws (x2).

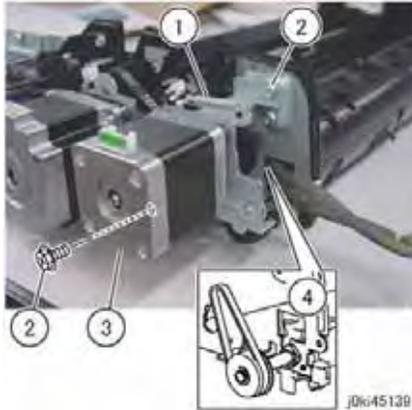
Figure 2 DADF Reg Motor Bracket Removal

11. Remove the DADF Registration Motor and the Bracket. ([Figure 2](#))
 - (1) Remove the spring.
 - (2) Remove the screws (x2).
 - (3) Remove the DADF Registration Motor and the Bracket.
 - (4) Remove the Belt.

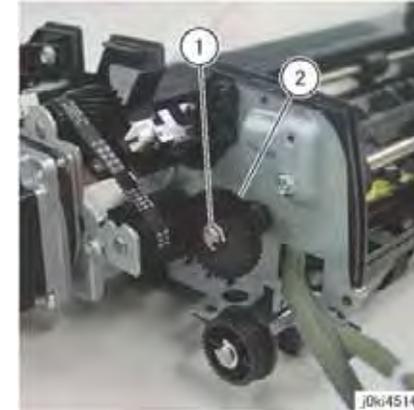
Figure 4 Rear Gear Removal

13. Remove the gear at the rear. (Figure 4)
 - (1) Remove the E-Clip.
 - (2) Remove the gear.

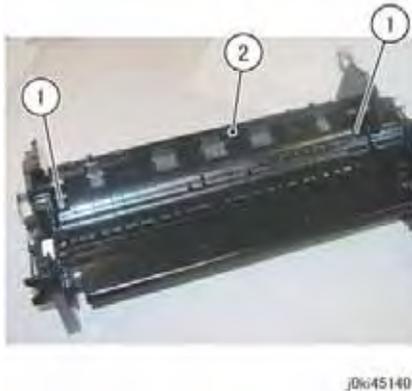
Figure 3 Invert Chute Removal

12. Remove the Invert Chute. (Figure 3)
 - (1) Remove the self-tapping screws (x2).
 - (2) Remove the Invert Chute.

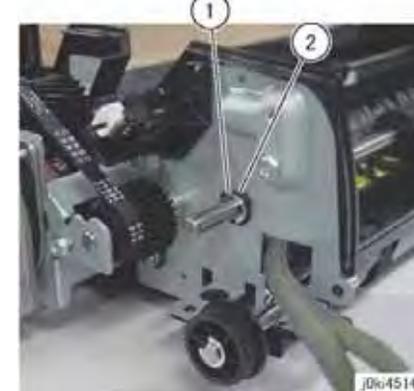
Figure 5 Bearing Removal

14. Remove the bearing at the rear. (Figure 5)
 - (1) Remove the E-Clip.
 - (2) Remove the bearing.

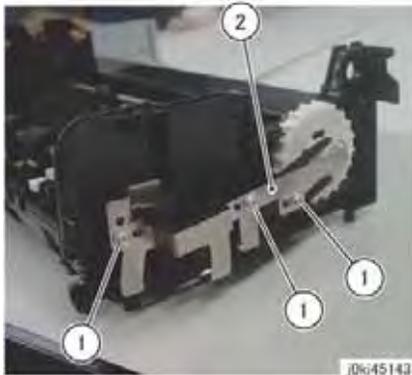
Figure 6 Ground Plate Removal

15. Remove the Ground Plate at the front. (Figure 6)
 - (1) Remove the self-tapping screws (x3).
 - (2) Remove the Ground Plate.

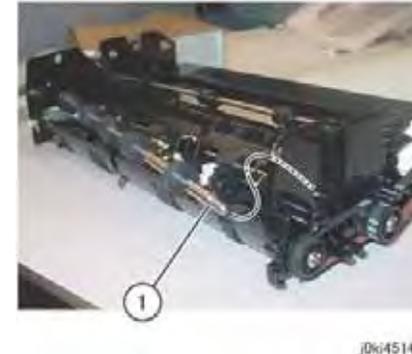
Figure 8 Takeaway Roll Removal

17. Remove the Takeaway Roll. (Figure 8)

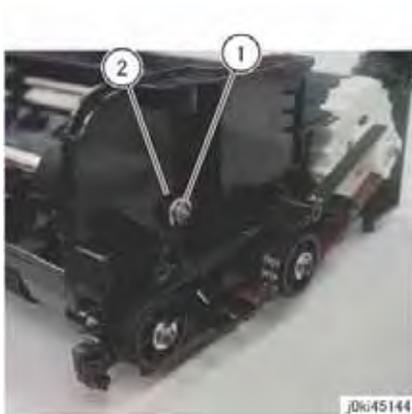
Figure 7 Front Bearing Removal

16. Remove the bearing at the front. (Figure 7)

- (1) Remove the E-Clip.
- (2) Remove the bearing.

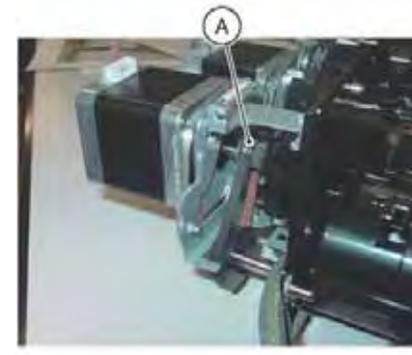
Figure 9 Belt Installation

1. To install, carry out the removal steps in reverse order.
2. Install the Belt (A) to the Pulley of the DADF Registration Motor. (Figure 9)

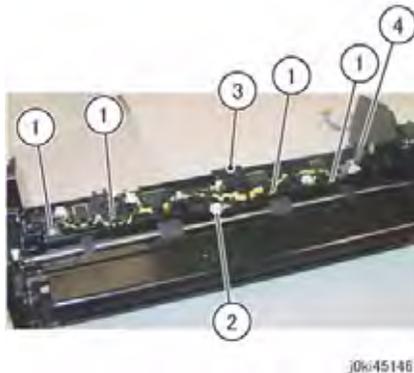
Figure 1 Sensor Bracket Removal

1. Switch off the power and disconnect the power cord.
2. Remove the DADF Front Cover. ([REP 5.3](#))
3. Remove the DADF Rear Cover. ([REP 5.4](#))
4. Remove the DADF. ([REP 5.1](#))
5. Remove the DADF Document Tray. ([REP 5.9](#))
6. Remove the DADF Feeder Assembly. ([REP 5.5](#))
7. Remove the Registration Chute. ([REP 5.14](#))
8. Remove the Top Cover. ([REP 5.10](#))
9. Remove the Harness Guide and the wire harness. ([REP 5.11](#))
10. Remove the Takeaway Roll. ([REP 5.16](#))
11. Remove the Sensor Bracket. ([Figure 1](#))
 - (1) Remove the self-tapping screws (x4).
 - (2) Disconnect the connector.
 - (3) Remove the Sensor Bracket.
 - (4) Pull out and remove the wire harnesses (x2) through the hole on the Frame.

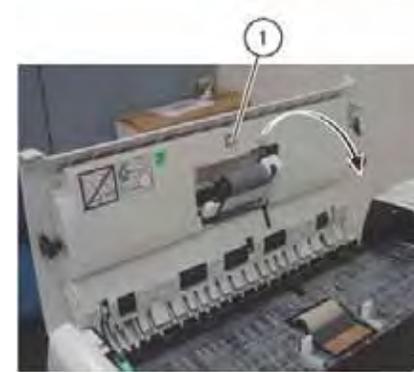
Figure 1 Feed Upper Chute

1. Switch off the power and disconnect the power cord.
2. Open the Top Cover.
3. Open the Feed Upper Chute. ([Figure 1](#))
 - (1) Release the hook and open the Feed Upper Chute.

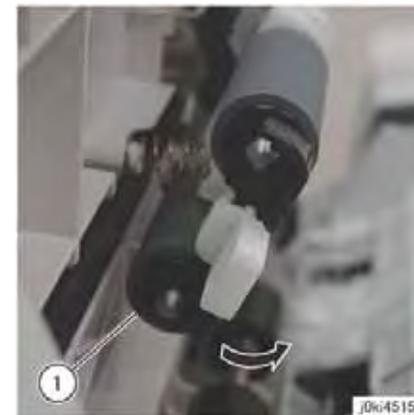
Figure 2 Housing Shift

4. Shift the housing. ([Figure 2](#))
Release the hook and shift the housing in the direction of the arrow.

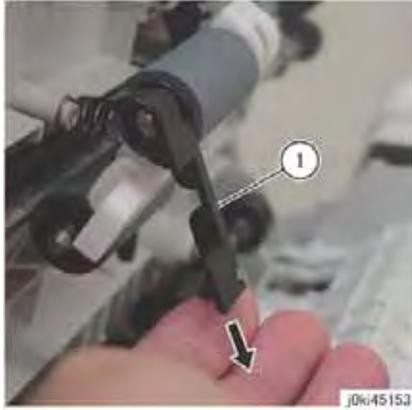
Figure 3 Housing Removal

5. Remove the housing. (Figure 3)
 - (1) Remove the housing in the direction of the arrow.

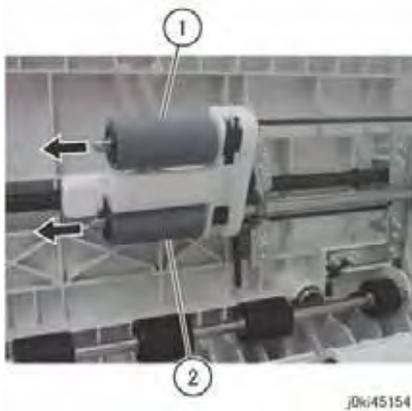
Figure 4 Nudger/Feed Roll Removal

6. Remove the Nudger Roll and the Feed Roll. (Figure 4)
 - (1) Remove the Nudger Roll.
 - (2) Remove the Feed Roll.

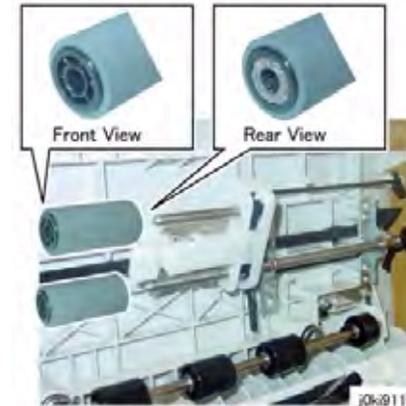
Figure 5 Nudger/Feed Roll Alignment

1. To install, carry out the removal steps in reverse order.
2. Install the Nudger/Feed Roll while aligning them as shown in the figure. (Figure 5)

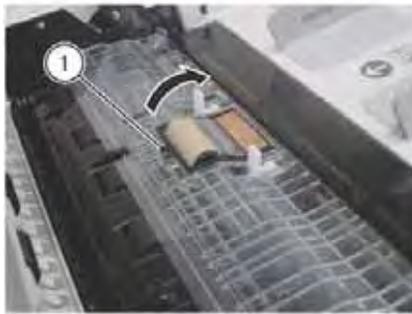
Figure 1 Retard Roll Cover

1. Switch off the power and disconnect the power cord.
2. Open the Top Cover.
3. Open the Retard Roll Cover. ([Figure 1](#))

- (1) Release the hook and open the Retard Roll Cover in the direction of the arrow.
4. Remove the Retard Roll. ([Figure 2](#))
Remove the Retard Roll.

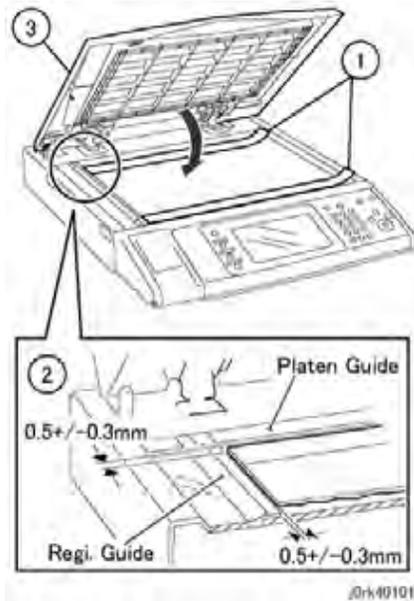
Figure 1 Positioning the Cushion

1. Place the Platen Cushion on the Platen Glass, at the proper position ([Figure 1](#)).
 - (1) Peel off the seals (x2).
 - (2) Leave a gap of $0.5 \pm 0.3\text{mm}$ between the Reg. Guide and the Platen Guide.
 - (3) Close the Platen Cover gently and press it onto the Platen Cushion.

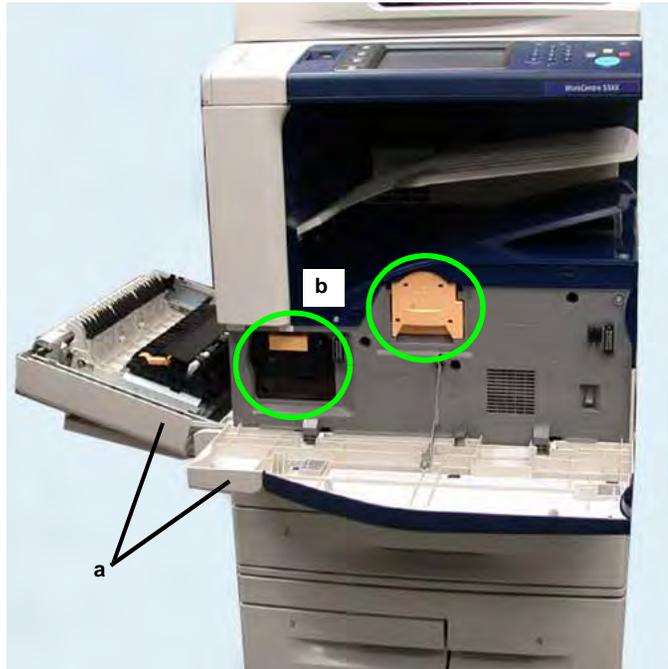
Figure 1 Removals

1. Switch off the power and disconnect the power cord.
2. Perform the following (Figure 1).
 - a. Open the Front Cover and the Left Hand Cover.
 - b. Remove the Xerographic Cartridge and the Toner Cartridge.
