WorkCentre 5335 Family Service Documentation

705P01303

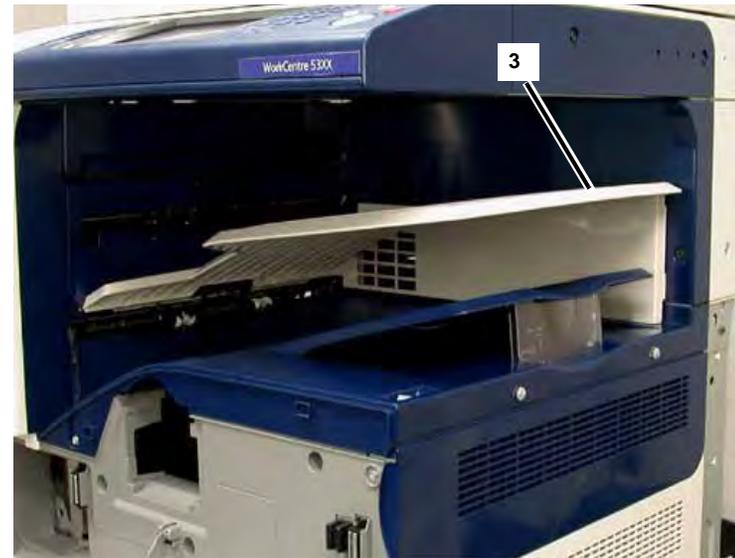
Figure 2 Tray Removal

3. Remove the Exit 2 Tray, release the Rear Locking Tab and remove the tray (Figure 2).

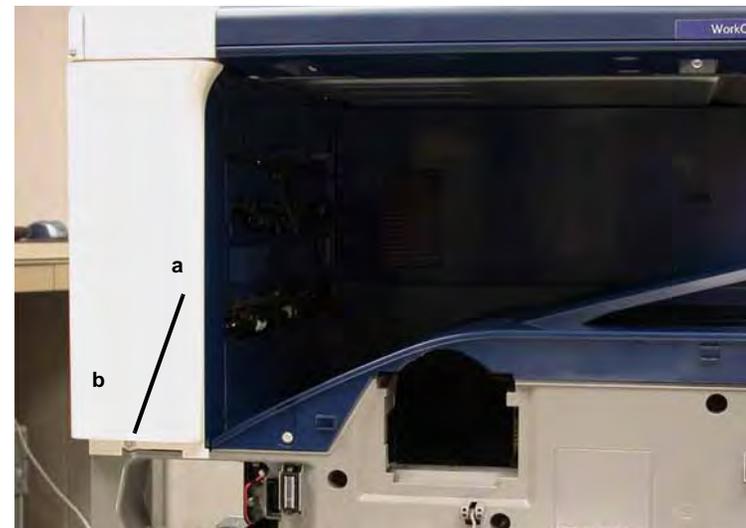
Figure 3 Cover Removal

4. Remove the Front Left Cover and Exit Front Cover (Figure 3).
 - a. Remove Screw (1).
 - b. Pull out the bottom of the Front Left Cover and remove the covers.

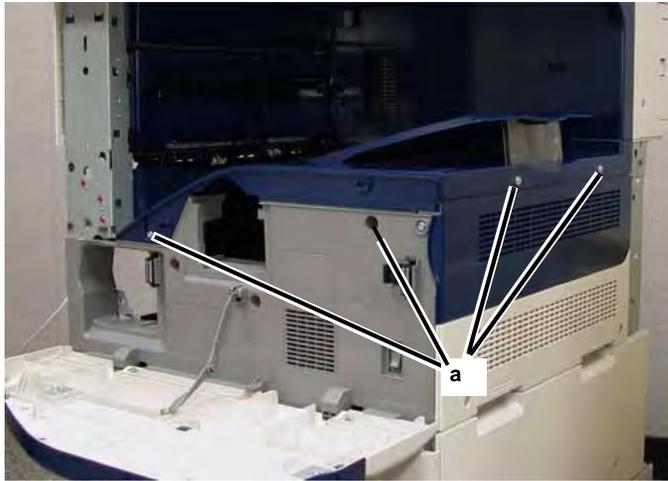
Figure 4 Removing Screws

5. Remove the Top Cover (Figure 4).
 - a. Remove the Screws (4).
 - b. Lift the cover up and remove it.

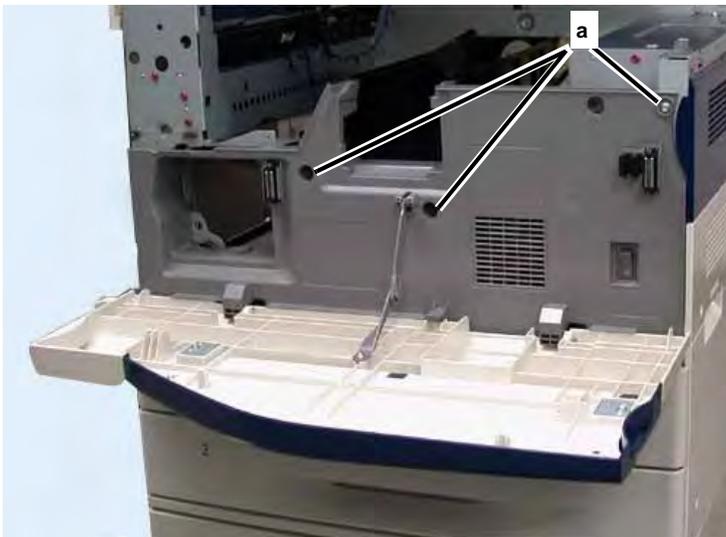
Figure 5 Removing Screws

6. Remove the Front Cover (Figure 5).
 - a. Remove the Screws (3).
 - b. Pull the top of the cover out and lift it off.

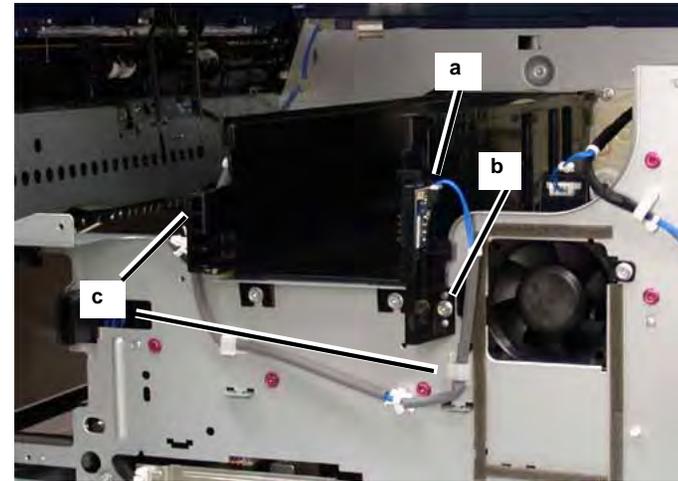
Figure 6 Wires

7. Remove the Toner Cartridge Connector (Figure 6).
 - a. Disconnect the PJ (1).
 - b. Remove Connector (1 Screw).
 - c. Release the wire harness from the front clamps and left side of the Cartridge Guide.

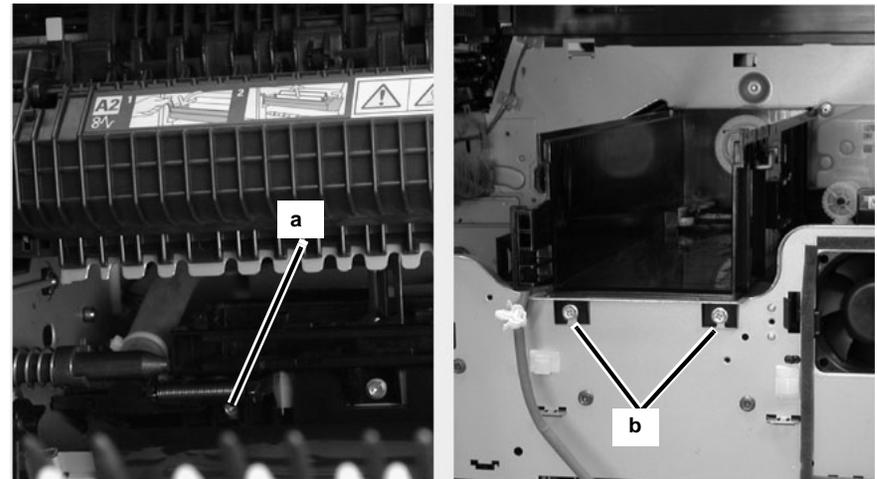
Figure 7 Removing Screws

8. Remove the Toner Cartridge Guide (Figure 7).
 - a. On the left rear of the guide, remove the Dispenser Tube Screw (1).
 - b. Loosen the front Screws (2).
 - c. Lift the front of the guide up and remove it.

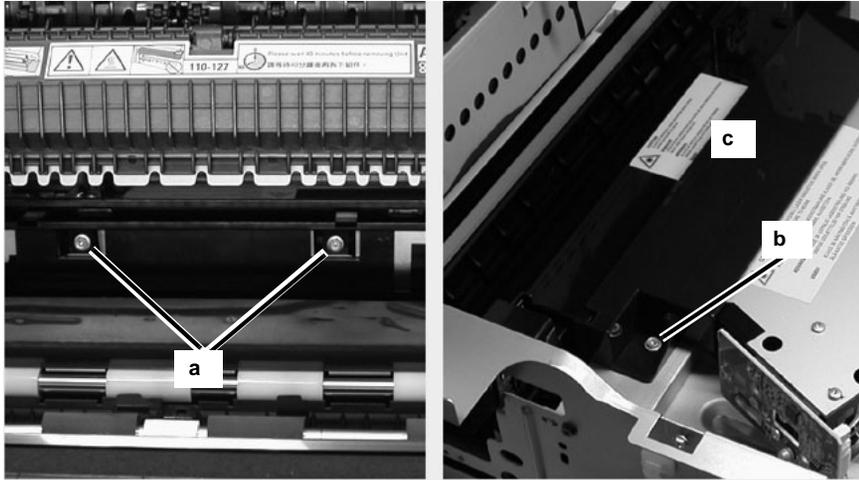
Figure 8 Removing Screws

9. Remove the ROS Cover (Figure 8).
 - a. Remove the Screws (2) on the left side of the cover.
 - b. Remove the top Screw (1).
 - c. Move the cover to the left and remove it.

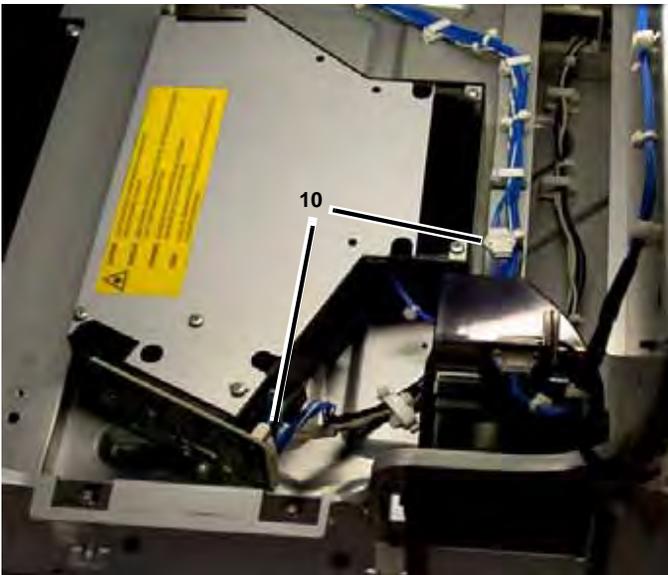
Figure 9 PJ's

10. Disconnect the ROS PJ's (4) and release the wire harness from the clamps (Figure 9).

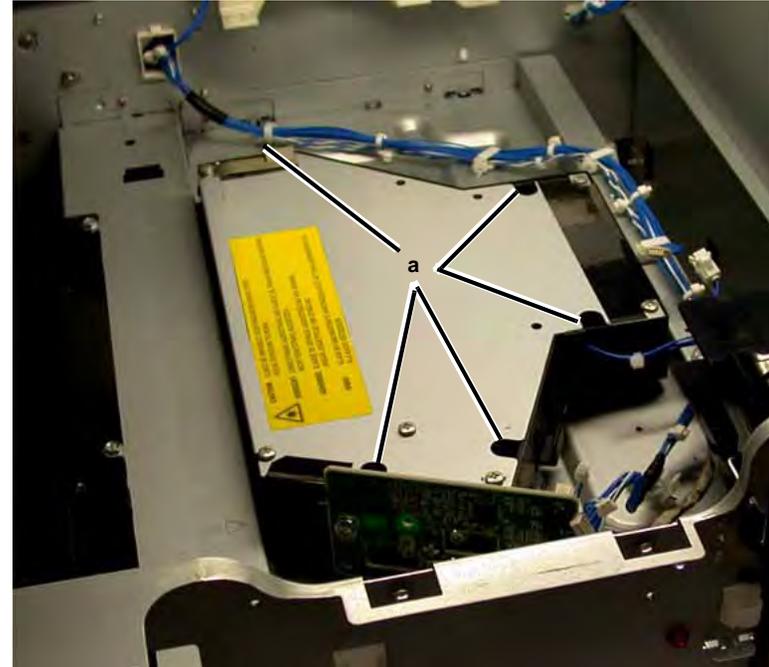
Figure 10 Removing Screws

NOTE: The ROS screws are longer than the other screws, keep them with the ROS for reinstallation.

11. Remove the ROS (Figure 10).
 - a. Remove the Screws (5).
 - b. Remove the ROS.

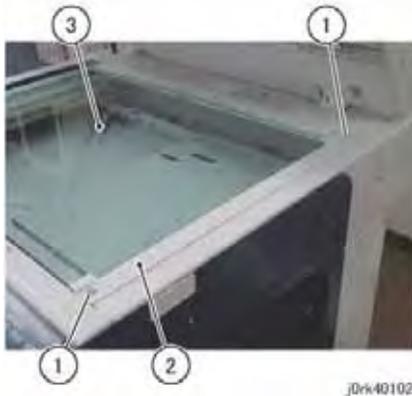
Figure 1 Platen Glass Removal

1. Switch off the power and disconnect the power cord.
2. Open the Platen Cover or DADF.
3. Remove the Platen Glass ([Figure 1](#))
 - (1) Remove the screws (x2).
 - (2) Remove the Right Side Plate.
 - (3) Remove the Platen Glass.

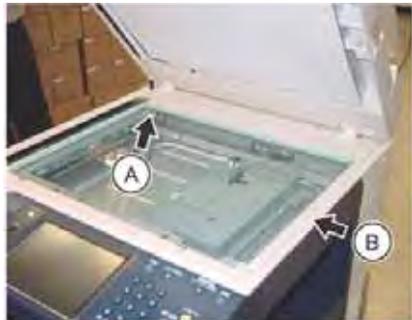
Figure 2 Platen Glass Positioning

NOTE: Push the Platen Glass in the direction of arrow A and the Right Side Plate in the direction of arrow B ([Figure 2](#))

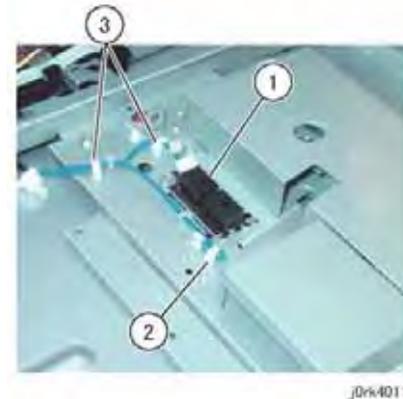
Figure 1 APS Sensor

1. Switch off the power and disconnect the power cord.
2. Remove the following parts:
 - Platen Glass ([REP 6.3](#))
 - Lens Cover ([PL 1.2](#))
3. Move the APS Sensor ([Figure 1](#))
 - (1) Remove the screw.
 - (2) Release the harness from the clamps (x3).
 - (3) Move the APS Sensor.

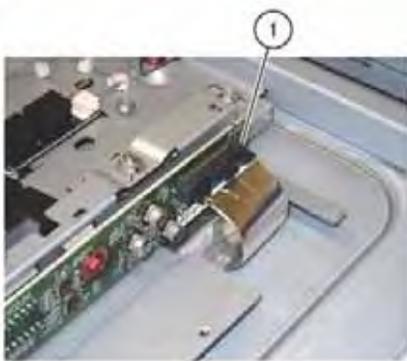
Figure 2 CCD Flexible Print Cable

4. Disconnect the CCD Flexible Print Cable ([Figure 2](#))
 - (1) Release the hook and disconnect the connector.

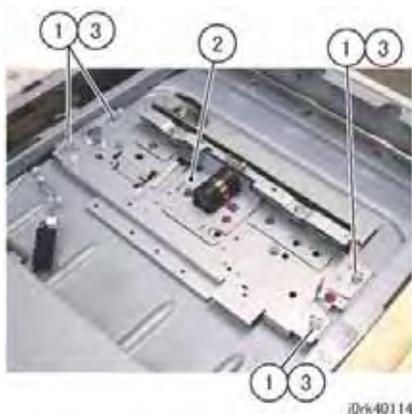
Figure 3 CCD Lens Assembly

5. Replace the CCD Lens Assembly (Figure 3)

NOTE: When removing the CCD Lens Assembly, never remove the screws (Red: x2) of the jig pin.

- (1) Remove the screws (x4).
- (2) Replace the CCD Lens Assembly.
- (3) Secure the CCD Lens Assembly by using the screws (x4).

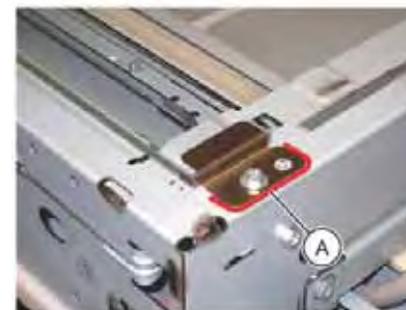
Figure 1 Front Support Installation Position

1. Switch off the power and disconnect the power cord.
2. Open the DADF or the Platen Cover.
3. Remove the following parts:
 - Platen Glass ([REP 6.3](#))
 - Control Panel Assembly ([REP 6.11](#))
 - IIT Left Cover ([PL 1.1](#))
4. Take note of the installation position of the Front Support ([Figure 1](#))
Mark position

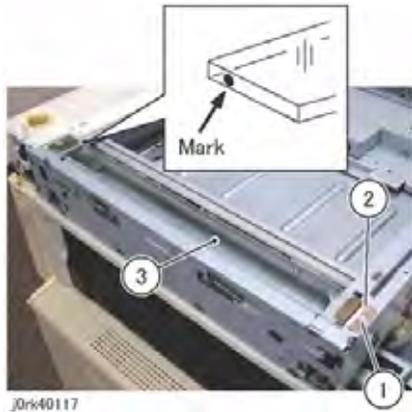
Figure 2 DADF Platen Glass Mark

5. Remove the DADF Platen Glass ([Figure 2](#))
 - (1) Remove the screw.
 - (2) Remove the Front Support.
 - (3) Remove the DADF Platen Glass.

When installing, place it such that the Mark is at the rear.

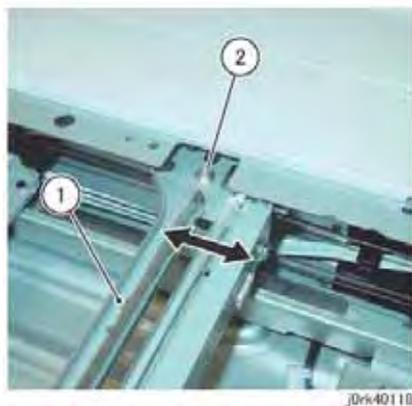
Figure 3 Full Carriage Cable

6. Unfasten the Full Rate Carriage from the Carriage Cable (Figure 3)
 - (1) Move the Full Rate Carriage to the notch on the frame.
 - (2) Remove the screw.

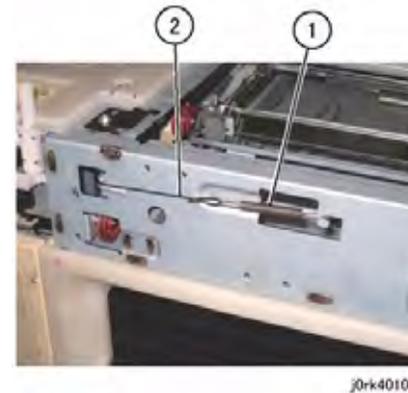
Figure 4 Carriage Cable Removal

7. Remove the Carriage Cable (Figure 4)
 - (1) Remove the spring from the Frame.
 - (2) Detach the cable from the spring.

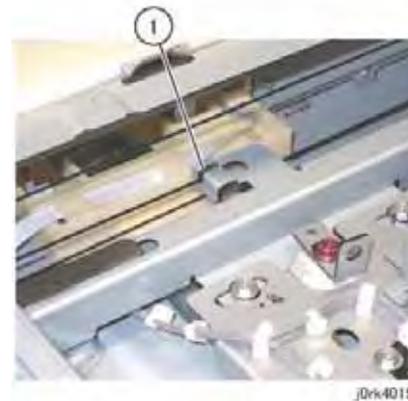
Figure 5 Carriage Cable Ball

8. Remove the Carriage Cable (Figure 5)
 - (1) Pull out the ball from the notch of the Frame and remove the Carriage Cable.

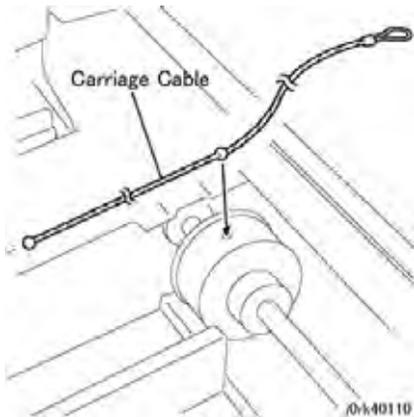
Figure 6 Carriage Cable

1. Insert the ball of the Carriage Cable into the groove of the pulley (Figure 6)

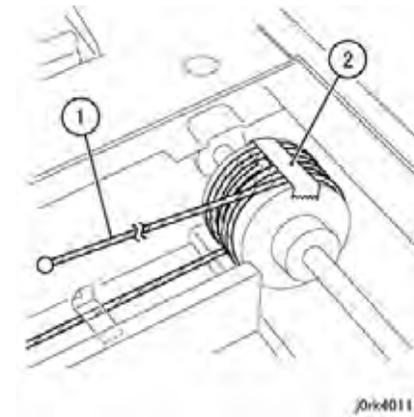
Figure 8 Taping Carriage Cable

3. Wind the Carriage Cable at the ball end around the pulley for 3 rounds (Figure 8)
 - (1) Wind the cable 3 rounds.
 - (2) Fix the cable wound on the pulley with tape to prevent it from getting loose.

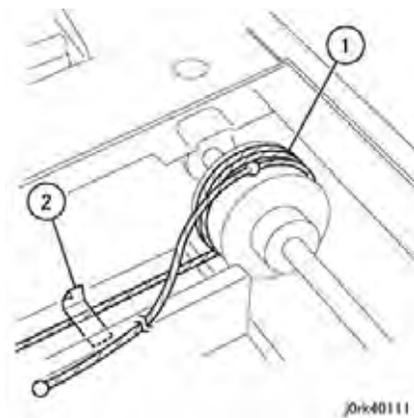
Figure 7 Winding Carriage Cable

2. Wind the Carriage Cable at the spring end around the pulley for 2.5 rounds (Figure 7)
 - (1) Wind the cable 2.5 rounds.
 - (2) Fix the cable at the spring end on the Frame with tape.

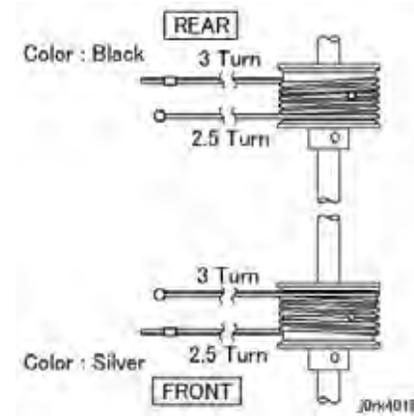
Figure 9 Front and Rear Carriage Cable

The figure below shows the number of rounds made by Carriage Cable at the front and rear (Figure 9)

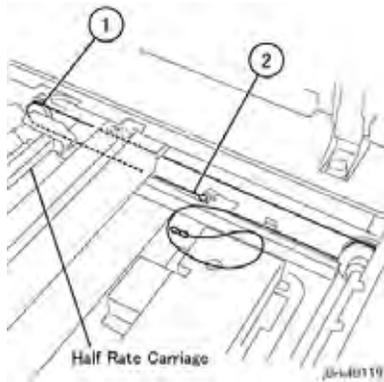
Figure 10 Installing Ball End

4. Install the ball end of the Carriage Cable (Figure 10)
 - (1) Hang the cable on the pulley at the front of the Half Rate Carriage.
 - (2) Hang the ball on the notch of the Frame.

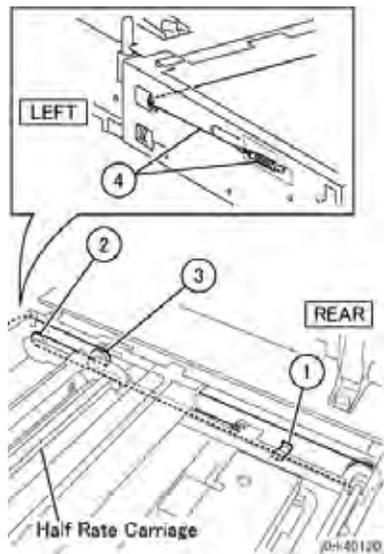
Figure 11 Carriage Cable Spring End

5. Install the spring end of the Carriage Cable (Figure 11)
 - (1) Peel off the tape that secures the cable.
 - (2) Hang the cable on the pulley.
 - (3) Hang it on the pulley at the rear of Half Rate Carriage.
 - (4) Hang the spring on the Cable and attach it to the Frame.

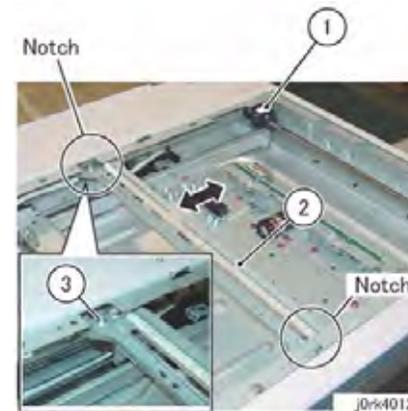
Figure 12 Full Rate Carriage

6. Affix the cable to the Full Rate Carriage (Figure 12)
 - (1) Peel off the tape.
 - (2) Move the Full Rate Carriage to the notch on the frame.

- (3) Affix the cable to the Full Rate Carriage.

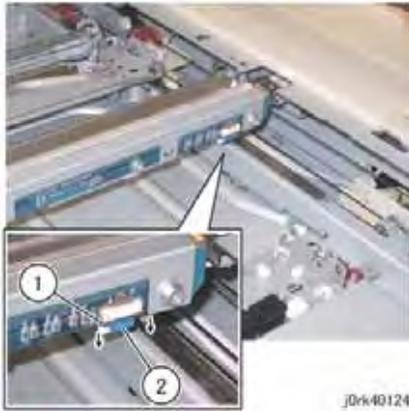
Figure 1 Disconnecting Lamp Wire Harness

1. Switch off the power and disconnect the power cord.
2. Open the Platen Cover or DADF.
3. Remove the Platen Glass (REP 6.3)
4. Move the Full Rate Carriage to the notch on the Frame.
5. Disconnect the Lamp Wire Harness (Figure 1)
 - (1) Move the Block of the Connector Housing in the direction of the arrow.
 - (2) Disconnect the Lamp Wire Harness.

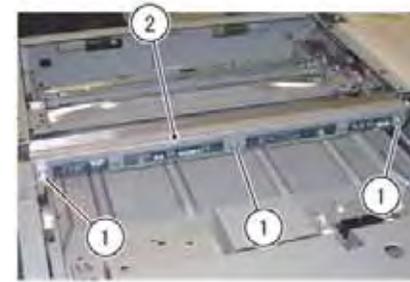
Figure 2 LED Bracket

6. Remove the LED Bracket (Figure 2)
 - (1) Remove the screws (x3).
 - (2) Remove the LED Bracket.

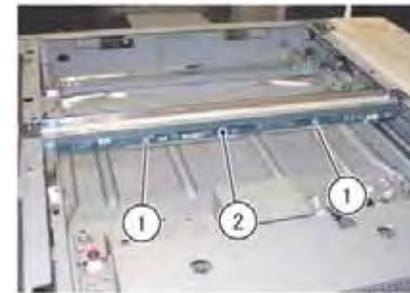
Figure 3 LED Lamp PWB Removal

7. Remove the LED Lamp PWB (Figure 3)
 - (1) Remove the screws (x2).
 - (2) Remove the LED Lamp PWB.

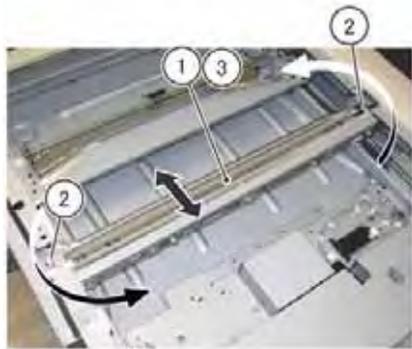
Figure 2 Full Rate Carriage Removal

4. Remove the Full Rate Carriage ([Figure 2](#))
 - (1) Move the Full Rate Carriage to the notch on the frame.
 - (2) Remove the screws (x2).
 - (3) Remove the Full Rate Carriage.

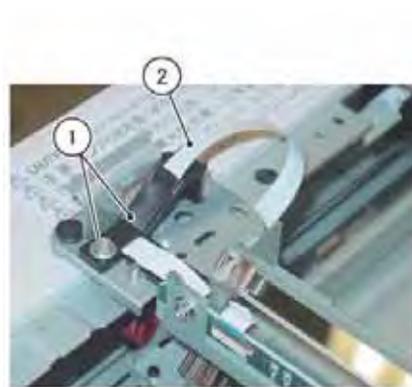
Figure 3 Full Rate Carriage Upside Down

5. Turn the Full Rate Carriage upside down.
6. Remove the Lamp Wire Harness from the Full Rate Carriage (Figure 3)
 - (1) Remove the Screw & Plate.
 - (2) Remove the Lamp Wire Harness.

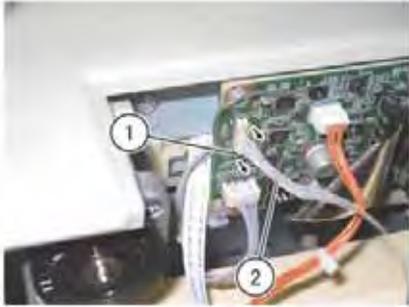
8. Remove the Lamp Wire Harness from the guide (Figure 5)
 - (1) Remove the Lamp Wire Harness from the guide.
9. Disconnect the Lamp Wire Harness from the IIT PWB (Figure 6)
 - (1) Move the Block of the Connector Housing in the direction of the arrow.
 - (2) Disconnect the Lamp Wire Harness.

Figure 6 IIT PWB

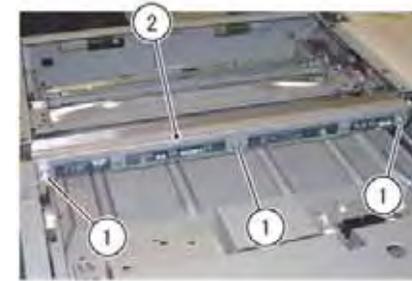
1. Switch off the power and disconnect the power cord.
2. Remove the DADF (REP 5.1)
3. Remove the Platen Glass (REP 6.3)
4. Move the Full Rate Carriage to the notch on the Frame.
5. Remove the LED Bracket (Figure 1)
 - (1) Remove the screws (x3).
 - (2) Remove the LED Bracket.

Figure 1 LED Bracket Removal

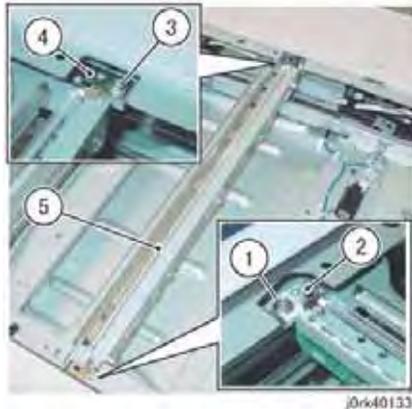
6. Remove the Light Guide (Figure 2)
 - (1) Remove the screw.
 - (2) Remove the Spring Guide.
 - (3) Remove the screw.
 - (4) Remove the Spring Guide.
 - (5) Remove the Light Guide.

Figure 2 Light Guide Removal

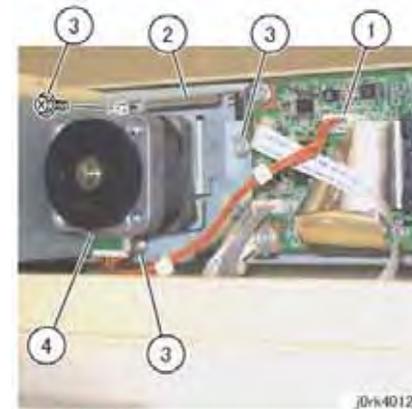
1. Switch off the power and disconnect the power cord.
2. Remove the following parts:
 - DADF ([REP 5.1](#))
 - Filter Cover ([PL 19.2](#))
 - Rear Upper Cover ([PL 19.2](#))
 - IIT Right Cover ([PL 1.1](#))
 - IIT Rear Cover ([PL 1.1](#))
 - IIT Top Cover ([PL 1.1](#))
3. Remove the Carriage Motor ([Figure 1](#))
 - (1) Disconnect the connector.
 - (2) Remove the spring.
 - (3) Remove the screws (x3).
 - (4) Remove the Carriage Motor.

Figure 1 Carriage Motor Removal

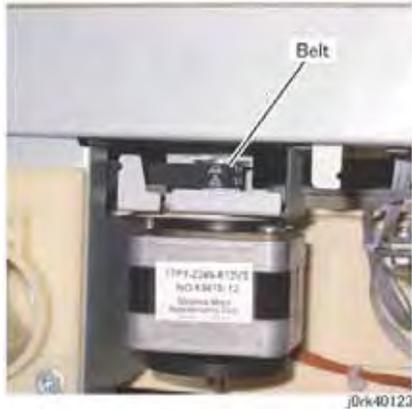
1. To install, carry out the removal steps in reverse order.
2. Install the Belt to the Pulley of the Carriage Motor ([Figure 2](#))

Figure 2 Belt Installation

3. Take note of the following points when installing the Carriage Motor.
 - (1) Attach the spring.
 - (2) Loosely affix the Carriage Motor that comes attached with a belt.
 - (3) Move the carriage to fit the belt.
 - (4) Secure the Carriage Motor to the Main Unit.
4. After installing the Carriage Motor, move the Full Rate Carriage back and forth and check that it is moving smoothly.

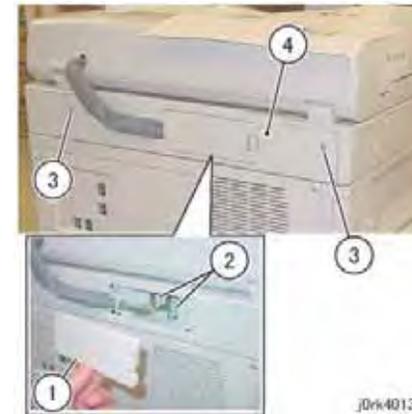
1. Switch off the power and disconnect the power cord.
2. Remove the IIT Rear Cover (Figure 1)
 - (1) Remove the cover.
 - (2) Disconnect the connectors (x2).
 - (3) Remove the screws (x2).
 - (4) Remove the IIT Rear Cover.

Figure 1 IIT Rear Cover Removal

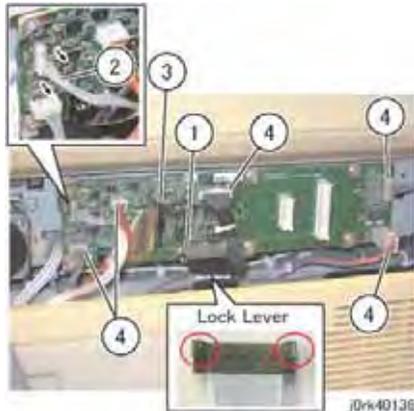
3. Disconnect the connectors that are connected at the rear side to the IIT PWB (Figure 2)
 - (1) Unlock to disconnect the Connector (P7191).
(Do not pull out the Harness directly.)
 - (2) Move the block of the Connector Housing in the direction of the arrow and disconnect the Flat Cable.
 - (3) Release the hook and disconnect the connector.
 - (4) Disconnect the connectors (x5).

Figure 2 IIT PWB Connectors

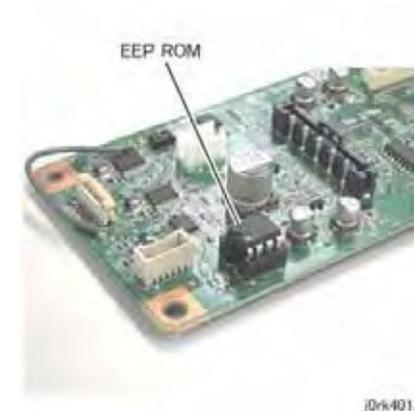
Figure 4 EEPROM

1. To install, carry out the removed steps in reverse order.
2. When the PWB is replaced, remove the EEPROM from the old PWB and install it onto the new one (Figure 4), refer to Downloading Software GP 16.

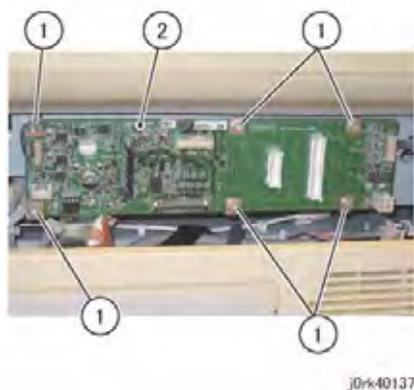
4. Remove the IIT PWB (Figure 3)
 - (1) Remove the screws (x6).
 - (2) Remove the IIT PWB.

Figure 3 IIT PWB Removal

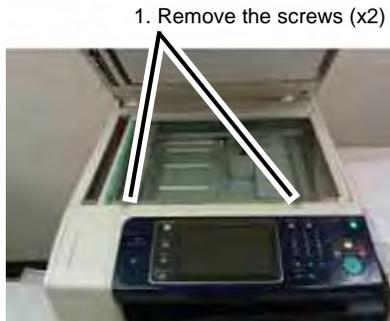
1. Switch off the power and disconnect the power cord.
2. Open the Platen Cover or DADF.
3. Remove the screws that secure the Control Panel (Figure 1).
 - (1) Remove the screws (x2).

Figure 1 Control Panel Screws

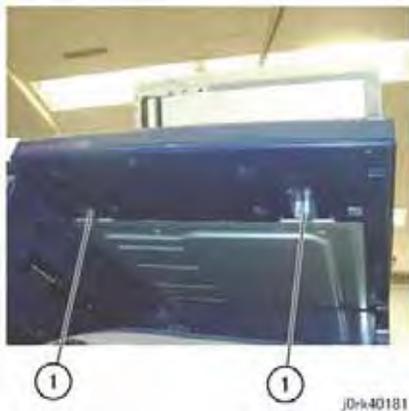
4. Remove the screws that secure the Control Panel (Figure 2).
 - (1) Remove the screws (x2).

Figure 2 Control Panel Screws

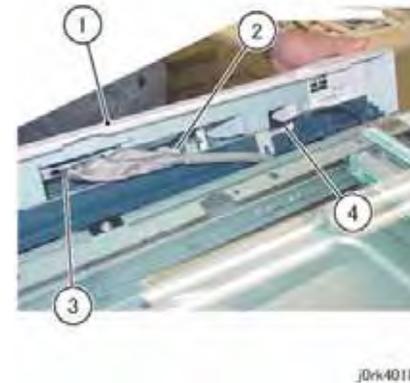
5. Remove the Control Panel (Figure 3).
 - (1) Hold the Control Panel and slide it slowly to the front.
 - (2) Release the UI Cable from the hooks.
 - (3) Release the hook at the bottom of the Connector Housing and disconnect the connector.

- (4) Disconnect the connector of the USB Cable.

Figure 3 Control Panel Removal

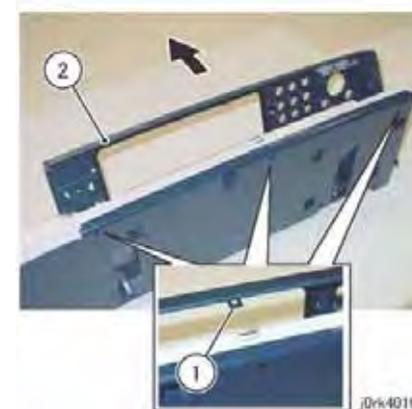
6. Turn the Control Panel upside down.
7. Remove the Overlay Cover (Figure 4).
 - (1) Release the hooks (x3) of the Overlay Cover.
 - (2) Remove the Overlay Cover in the direction of the arrow.

Figure 4 Overlay Cover Removal

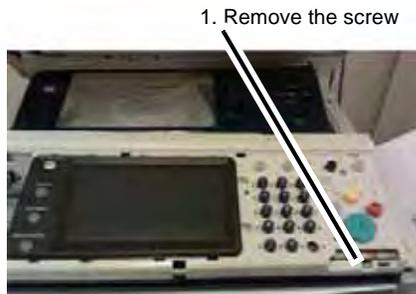
8. Turn the Control Panel so that the screen is face up.
9. Remove the self-tapping screw that secures the UI Lower Cover (Figure 5).

Figure 5 UI Lower Cover Removal

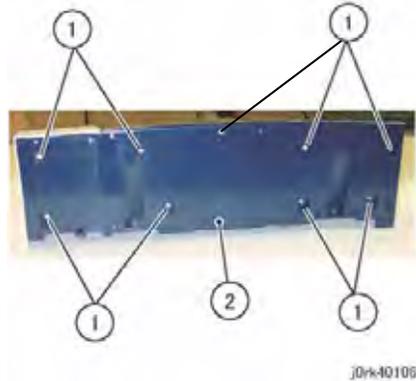
10. Turn the Control Panel upside down.
11. Remove the UI Lower Cover (Figure 6).
 - (1) Remove the self-tapping screws (x9).
 - (2) Remove the UI Lower Cover.

Figure 6 UI Lower Cover Removal

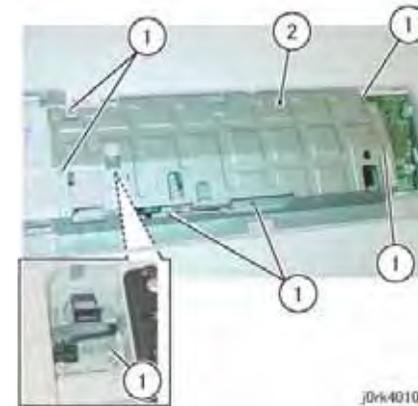
12. Remove the Base Frame (Figure 7).
 - (1) Remove the self-tapping screws (x7).
 - (2) Remove the Base Frame.

Figure 7 Base Frame Removal

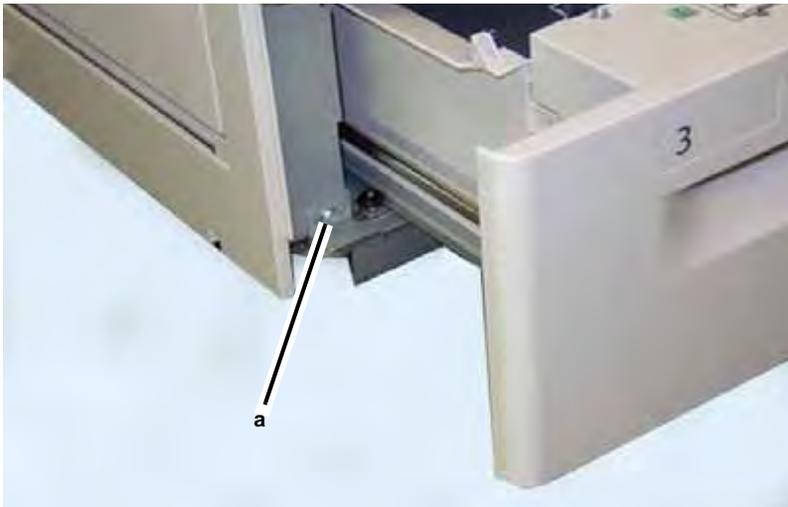
1. Remove the paper from the tray.
2. Pull the tray open.
3. Remove Paper Tray 3.
 - a. Loosen the screw holding the stop bracket and move the stop bracket away from the tray ([Figure 1](#)).
 - b. Remove the tray.

Figure 1 Removing Screw

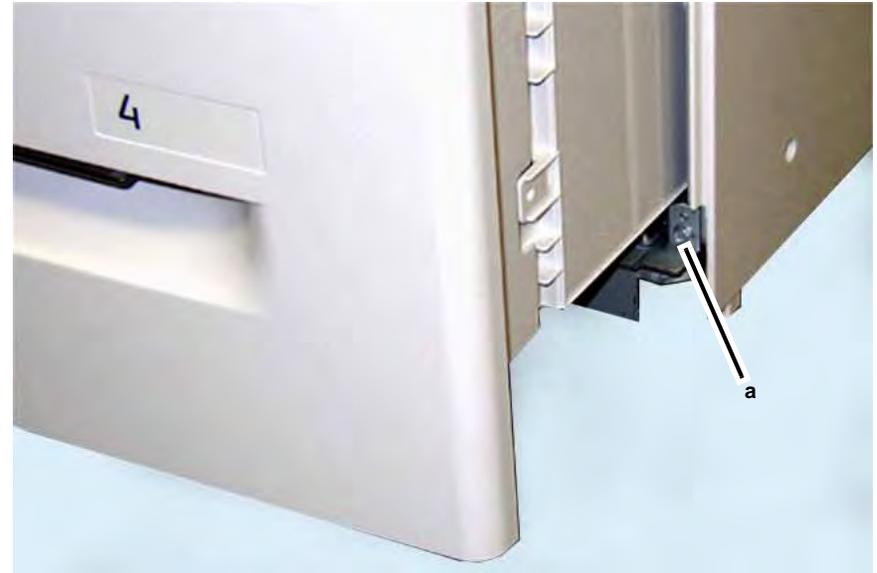
1. Remove the paper from the tray.
2. Pull the tray open.
3. Remove Paper Tray 4.
 - a. Remove the screw and stop bracket ([Figure 2](#)).
 - b. Remove the tray.

Figure 2 Removing Screw

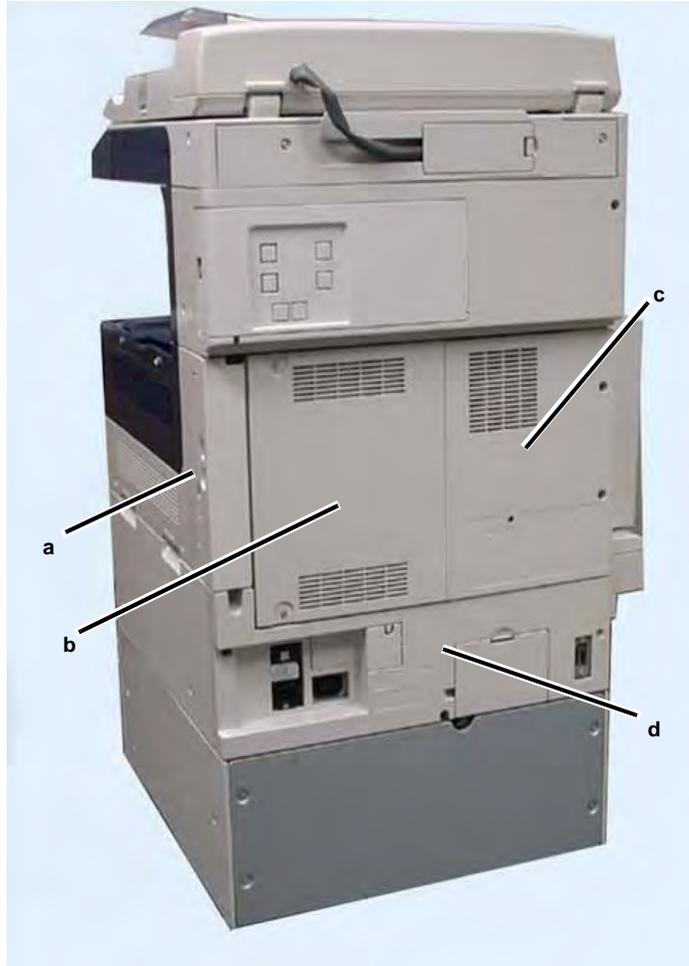
1. Switch off the power and disconnect the power cord.
2. Remove the following covers (Figure 1).
 - a. Pull off the ESS Cap Cover.
 - b. ESS Cover (2 Screws).
 - c. Left Rear Middle Cover (2 Screws).
 - d. Rear Lower Cover (3 Screws).

Figure 1 Removing Covers

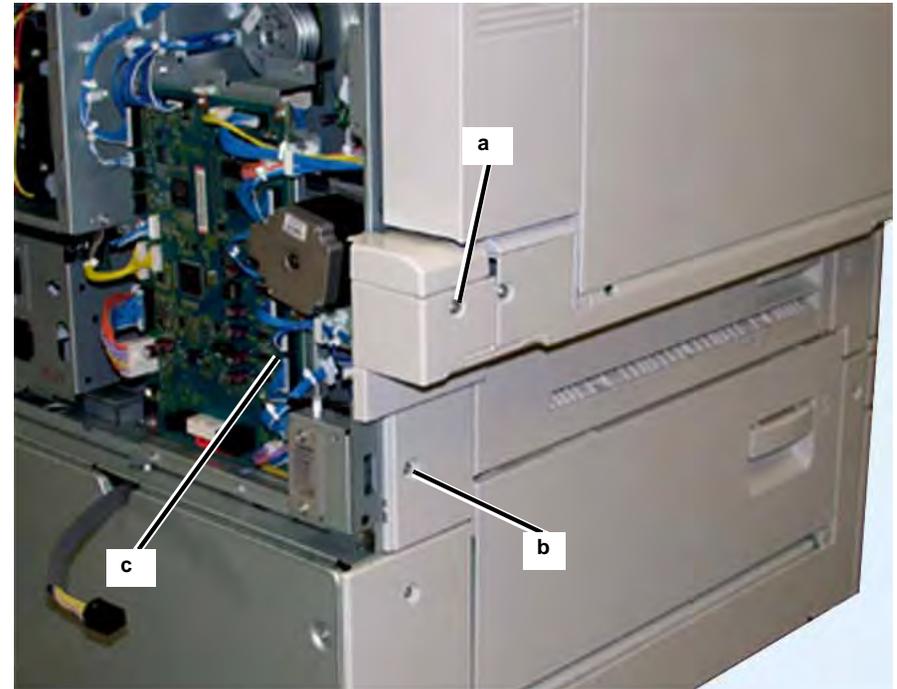
3. Perform the following steps (Figure 2).
 - a. Remove the Left Rear Covers (1 Screw).
 - b. Remove the Left Rear Lower Cover (1 Screw).
 - c. Disconnect P/J406 from the MCU PWB and release the wire harness to the MSI from the clamps.

Figure 2 Removing Screws

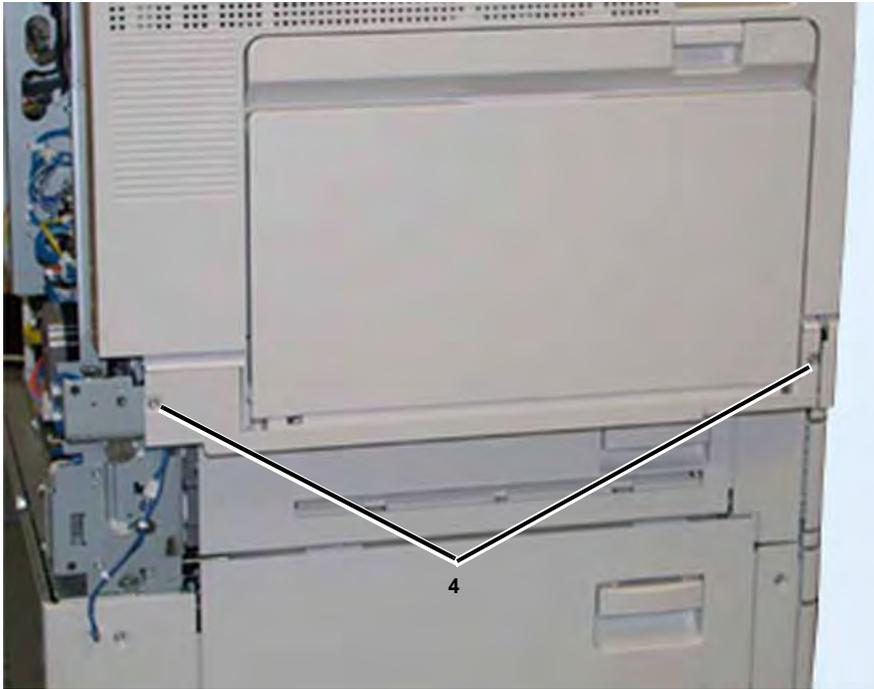
Support the MSI when removing the screws to prevent damaging the MSI.

4. Remove the screws (2) and slide out the MSI (Figure 3).

Figure 3 Removing Screws

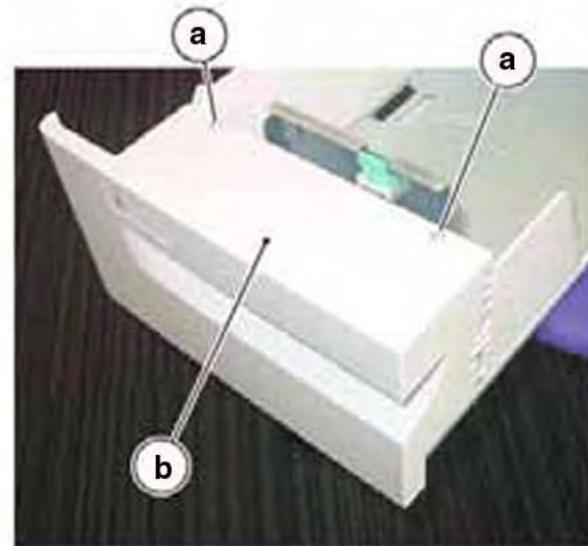
1. Switch off the power and disconnect the power cord.
2. Remove Paper Tray 3 [REP 7.1](#).
3. Remove the Tray 3 Cover (Figure 1):
 - a. Remove the Screws (2).
 - b. Remove the Cover.

Figure 1 Cover Removal

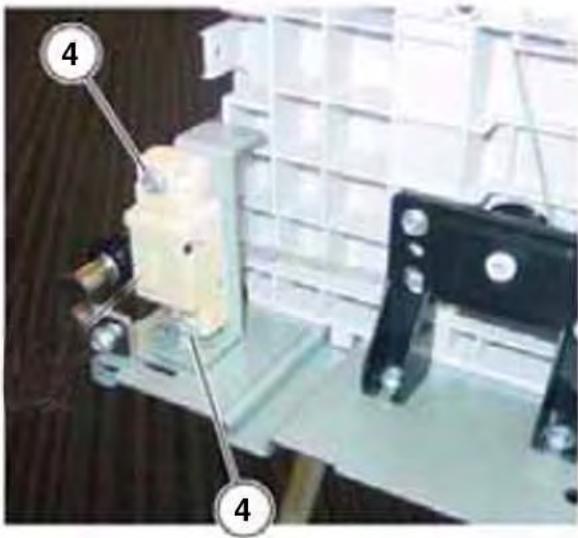
4. Remove the Screws (2) and the Brake (Figure 2).

Figure 2 Brake Removal

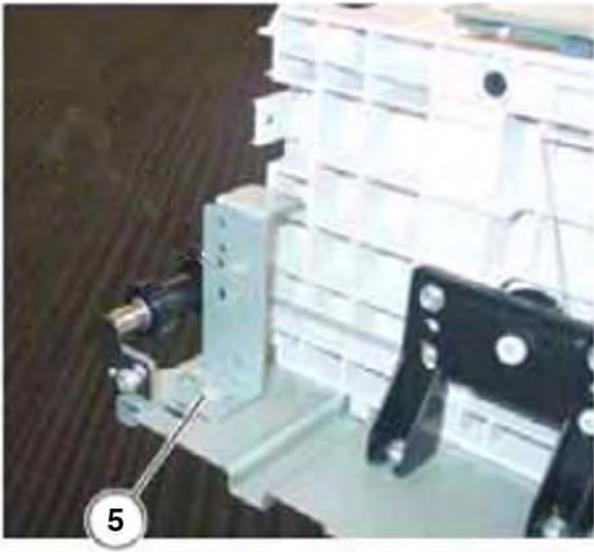
5. Remove the Screw (1) and Bracket (Figure 3).

Figure 3 Bracket Removal

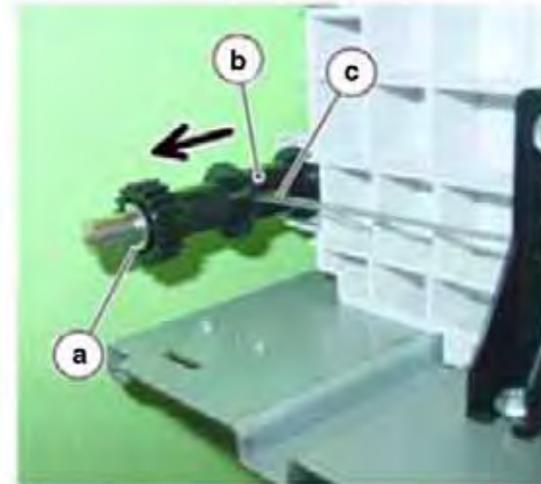
6. Release the Cables from the Shaft (Figure 4):
 - a. Remove the E-Ring and Gear.
 - b. Slide the Pulley.
 - c. Release the Cables from the Shaft detente.

Figure 4 Cable Release

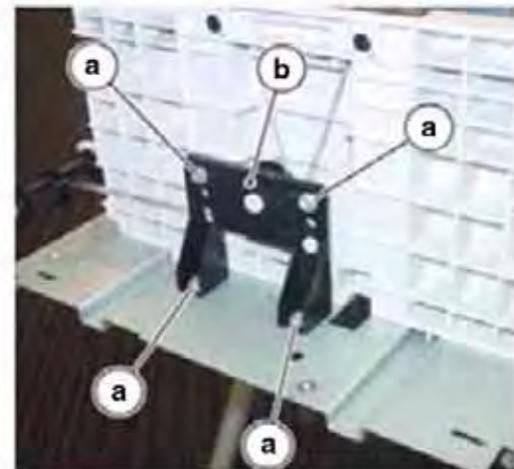
7. Remove the Guide (Figure 5):
 - a. Remove the Screws (4).
 - b. Remove the Guide.

Figure 5 Guide Removal

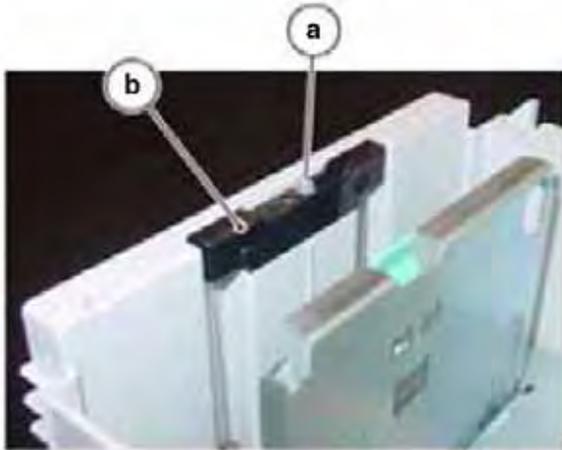
8. Remove the Guide (Figure 6):
 - a. Remove the Screw (1).
 - b. Remove the Guide.

Figure 6 Guide Removal

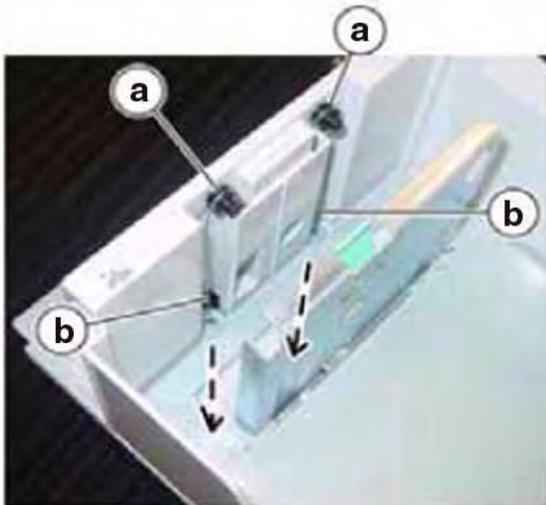
9. Remove the Cables (Figure 7):
 - a. Remove the Pulleys (2).
 - b. Raise the Plate and remove the Cables through the plate holes.

Figure 7 Cable Removal

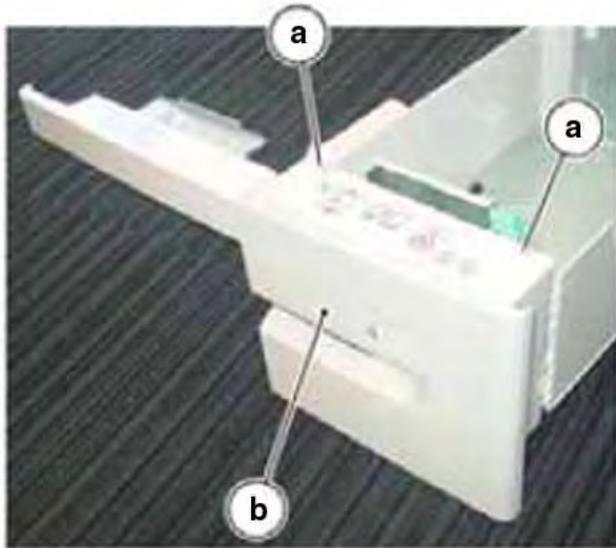
1. Switch off the power and disconnect the power cord.
2. Remove Paper Tray 4 [REP 7.1](#).
3. Remove the Cover ([Figure 1](#)):
 - a. Remove the Screws (2).
 - b. Remove the Cover.

Figure 1 Cover Removal

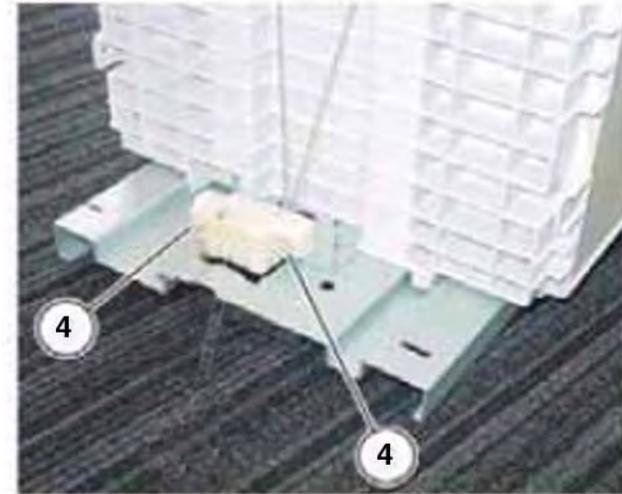
4. Remove the Screws (2) and the Brake ([Figure 2](#)).

Figure 2 Brake Removal

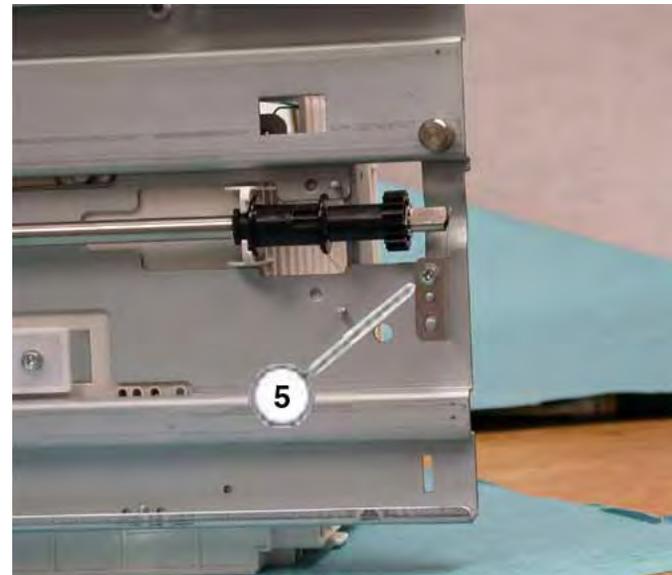
5. Remove the Screw (1) and Spring ([Figure 3](#)).

Figure 3 Spring Removal

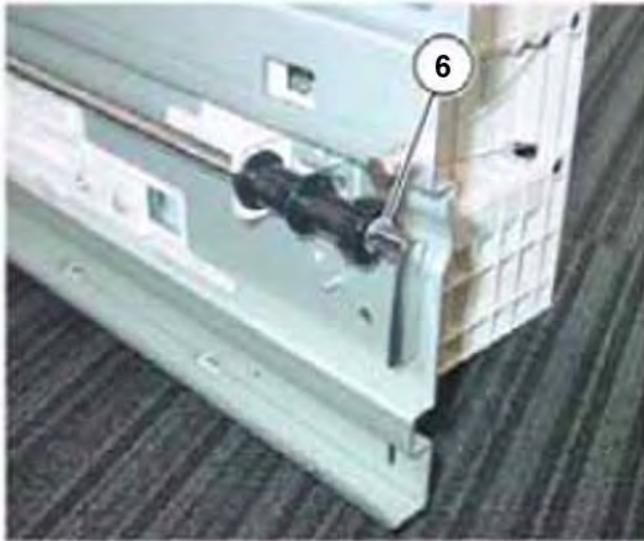
6. Remove the E-Ring (Figure 4).

Figure 4 E-Ring Removal

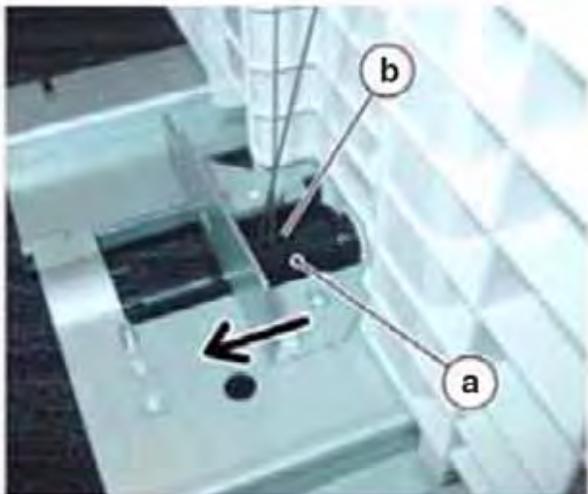
7. Release the Cables from the Shaft (Figure 5):
- Slide the Pulley.
 - Release the Cables from the Shaft detente.

Figure 5 Cable Release

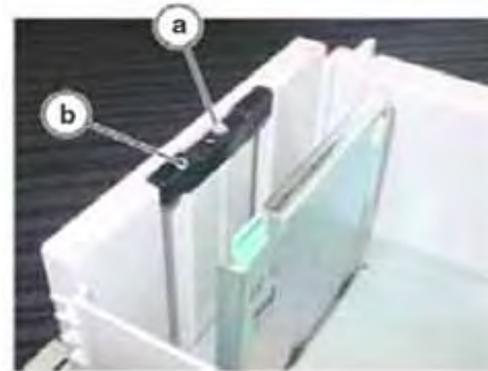
8. Remove the Guide (Figure 6):
- Remove the Screw (1).
 - Remove the Guide.

Figure 6 Guide Removal

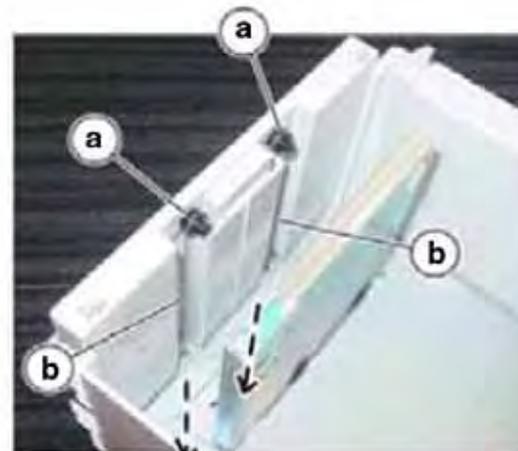
9. Remove the Cables (Figure 7):
- Remove the Pulleys (2).
 - Raise the Plate and remove the Cables through the plate holes.

Figure 7 Cable Removal

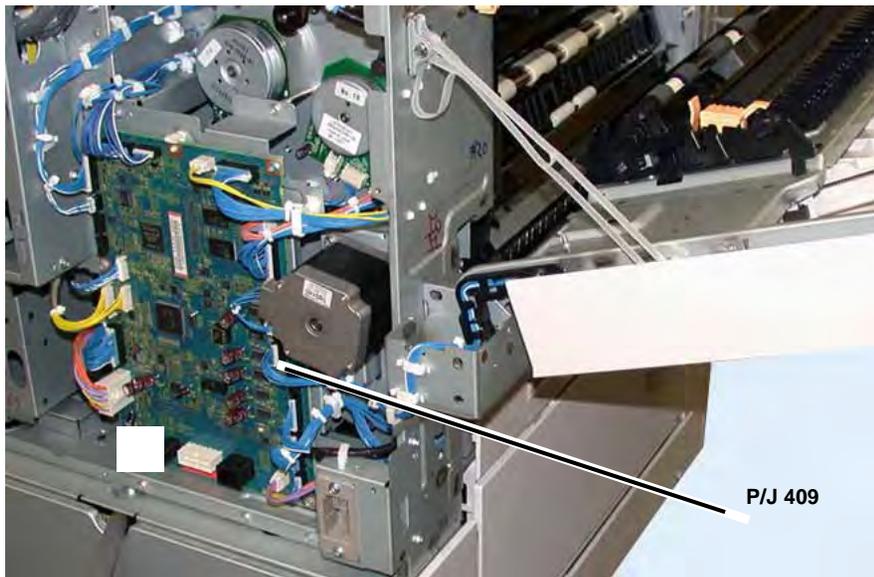
1. Switch off the power and disconnect the power cord.
2. Remove Paper Trays 1 and 2.
 - a. Remove the paper from the trays.
 - b. Pull the tray open.
 - c. Lift up the front of the tray so the rollers clear the stops, and remove the tray.
3. Remove the MSI [REP 7.2](#).
4. Perform the following ([Figure 1](#)).
 - a. Open the Left Hand Cover.
 - b. Disconnect [P/J409](#) on the MCU PWB, and release the wire harness from the clamps.

Figure 1 P/Js

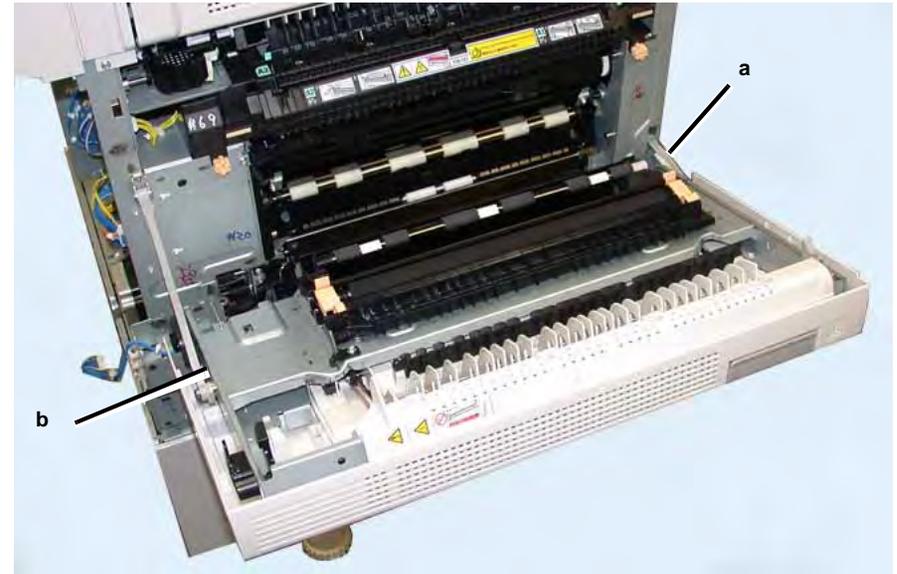
NOTE: Support the Left Hand Cover Assembly when releasing the supports to prevent damaging the cover.

5. Remove the Left Hand Cover Assembly ([Figure 2](#)).
 - a. Twist the Front Support and remove it from the slot.
 - b. Remove the K-Clip, and remove the Rear Support from the pin.
 - c. Move the cover down to a horizontal position, then lift it off the pivots.

Figure 2 Left Hand Cover

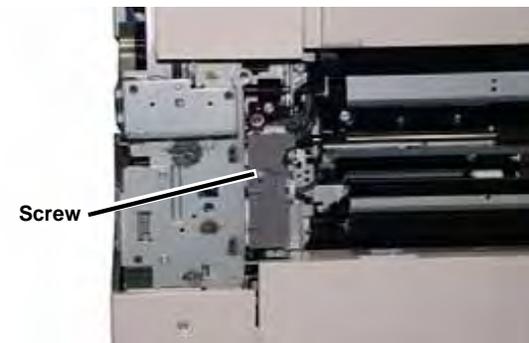
NOTE: The harness cover screw has a different thread than the other screws, keep it with the harness cover for re-installation.

6. Remove the harness cover (1 Screw) ([Figure 3](#)).

Figure 3 Removing Screw

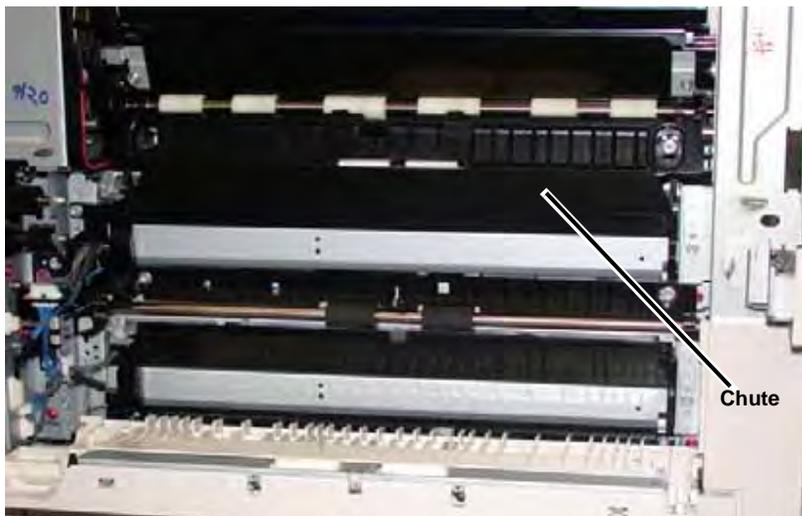
7. Remove Feeder 1 Chute (Figure 4).

Figure 4 Chute

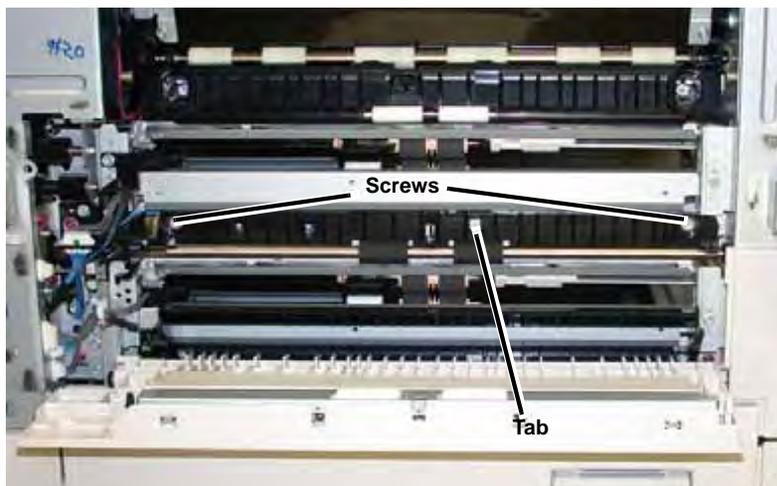
Figure 5 Removing Screws

NOTE: Make note of how the Sensor Wires are routed through the retainers on the chute to avoid pinching the wires when reinstalling the chute.

- a. Remove the Screws (2).
- b. Release the Tab, and remove the chute.

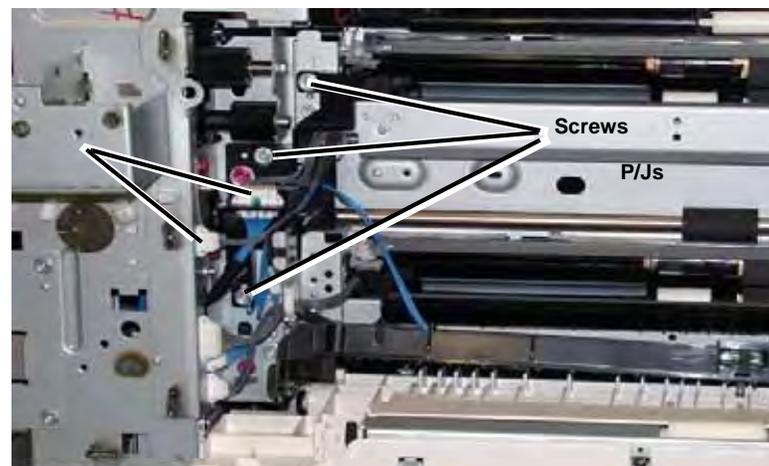
Figure 6 Removing Screws & P/J's

9. Perform the following (Figure 6).
 - a. Disconnect Feeder 1 P/J's (2).
 - b. Loosen the harness bracket, remove the Screws (3).
