WorkCentre 5335 Family Service Documentation

705P01303

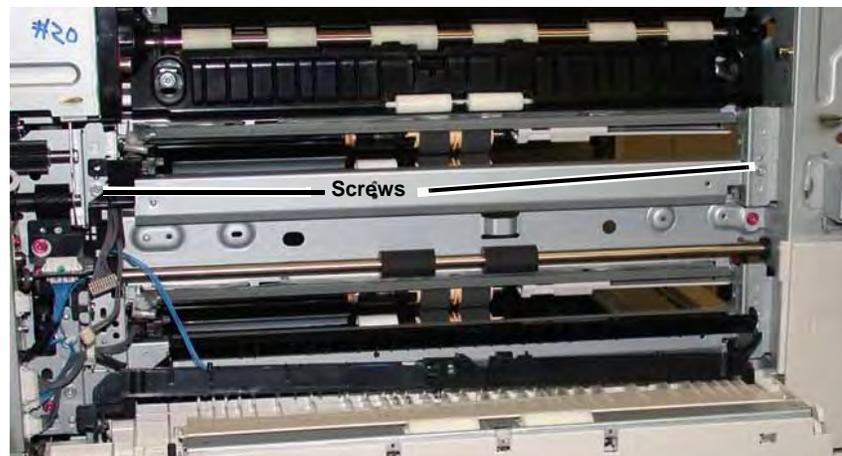
Figure 7 Removing Screws

10. Remove Feeder 1 (Figure 7).
 - a. Remove the Screws (2).
 - b. First, slide out the front of the feeder; then remove it.

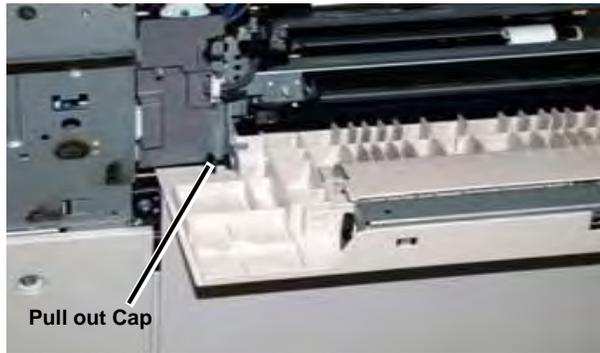
Figure 1 Removing Cover

1. Switch off the Power and disconnect the power cord.
2. Remove Paper Tray 2:
 - a. Remove the paper from the tray.
 - b. Pull the tray open.
 - c. Lift up the front of the tray so the rollers clear the stops and remove the tray.
3. Remove the MSI [REP 7.2](#).
4. Remove the Lower Left Hand Cover ([Figure 1](#)).
 - a. Pull out the cap on the Locking Hinge Pin and remove the pin.
 - b. Raise the cover, then move the rear of the cover out and remove the cover from the front pivot.

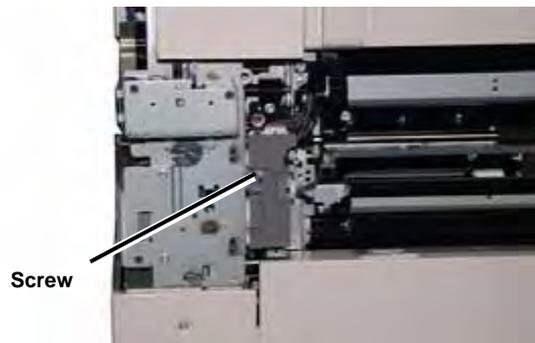
Figure 2 Removing Screw

NOTE: The harness cover screw has a different thread than the other screws, keep it with the harness cover for re-installation.

5. Remove the harness cover (1 Screw) ([Figure 2](#)).

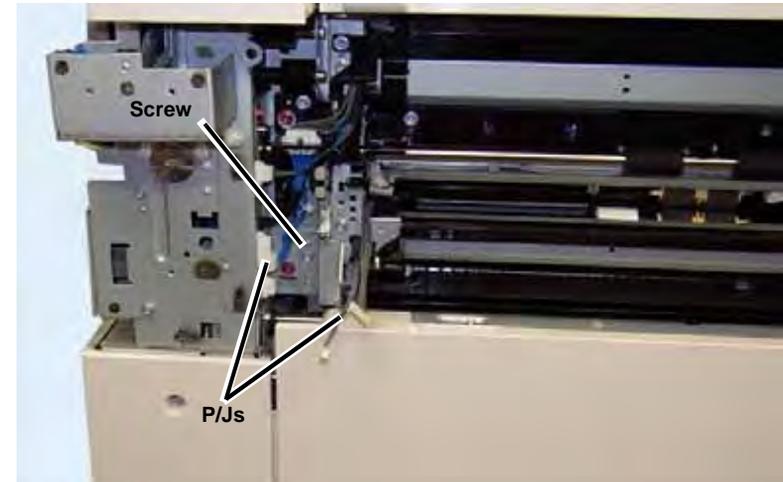
Figure 3 Removing Screws & P/J's

6. Perform the following ([Figure 3](#)).
 - a. Disconnect Feeder 2 P/J's (2) and release the harness from the clamp.
 - b. Remove the Pivot Bracket (1 Screw).

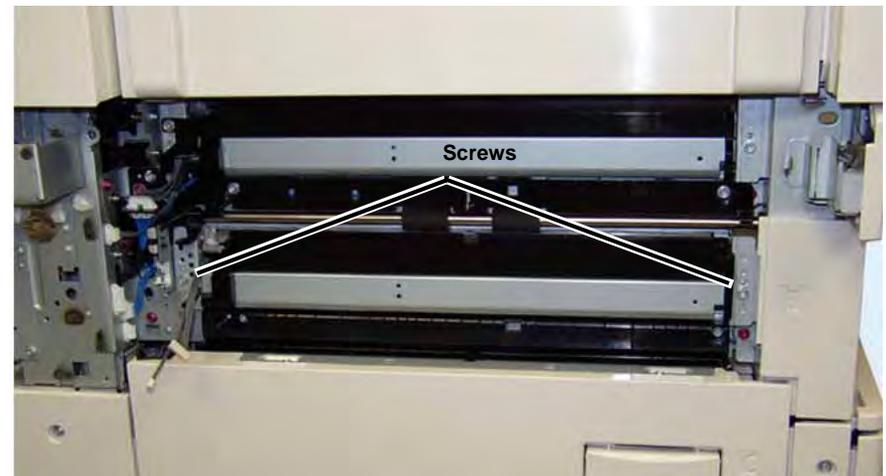
Figure 4 Removal

7. Remove Feeder 2 ([Figure 4](#)).
 - a. Remove the screws (2).
 - b. First, slide out the front of the feeder, then remove it.

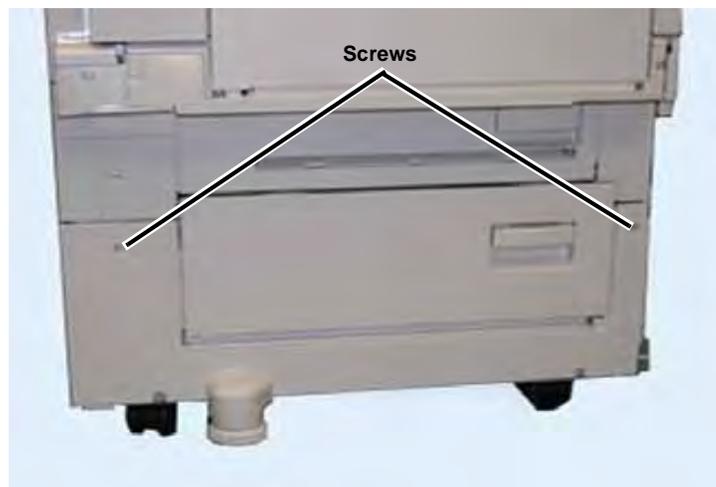
Figure 1 Covers

1. Switch off the power and disconnect the power cord.
2. Remove Paper Trays 2, 3, and 4 [REP 7.1](#).
3. Perform the following ([Figure 1](#)).
 - a. Remove the Left Lower Cover (2 Screws).
 - b. Open the Left Cover Assembly.

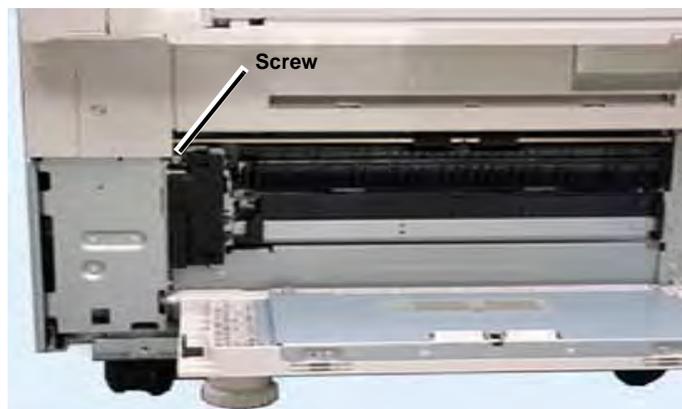
Figure 2 Removing Screw

4. Remove the Harness Cover (1 Screw) ([Figure 2](#)).

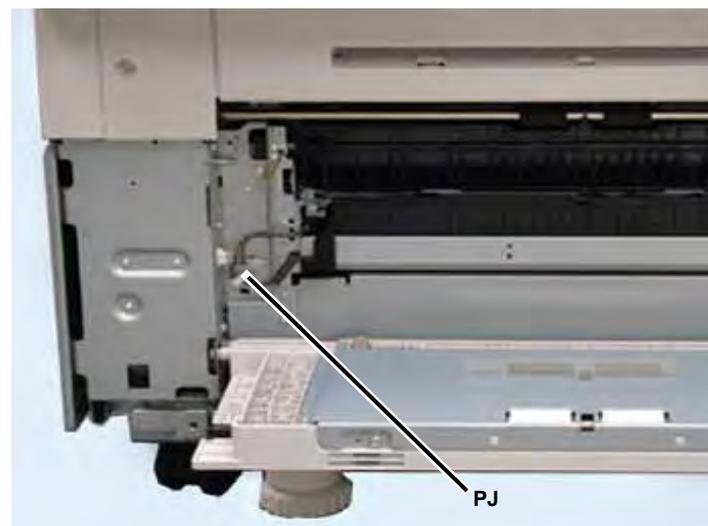
Figure 3 P/J's

5. Disconnect Feeder 3 P/J's (2), and release the harness from the clamp ([Figure 3](#)).

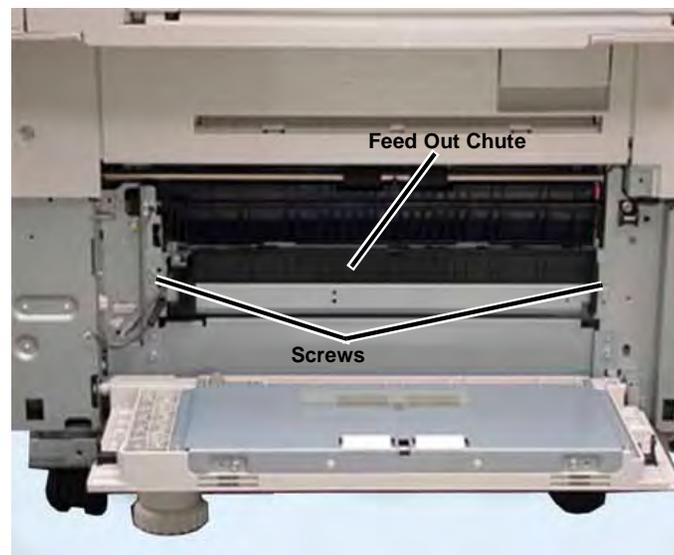
Figure 4 Removal

6. Perform the following ([Figure 4](#)).
 - a. Removing the Feed Out Chute.
 - b. Remove Tray 3 Feeder left side mounting screws (2).

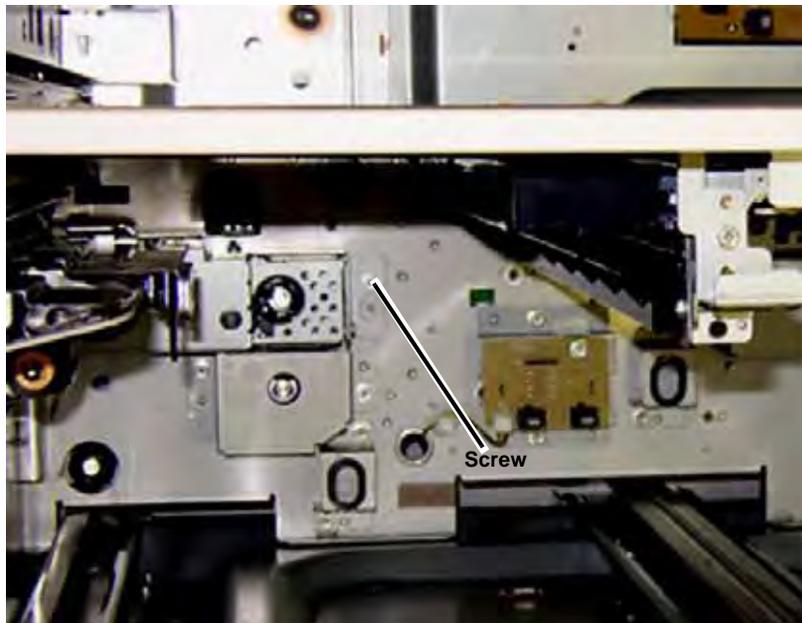
Figure 5 Removal

7. Remove Feeder 3 (Figure 5).
 - a. Remove the inside rear mounting screw (1)
 - b. Raise the right rear of Feeder 3 to clear the drive gear, then move the front of Feeder 3 to the left and slide it out.

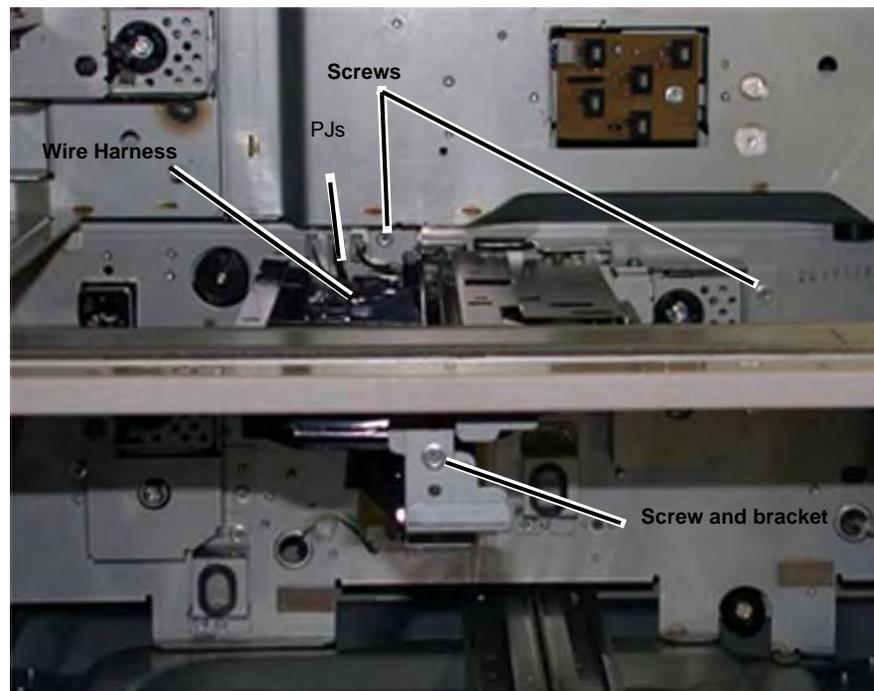
Figure 1 Removing Screws & P/J's

Be sure to support Feeder 4 when removing the screws and bracket to prevent damaging the feeder.

3. Remove Feeder 4 (Figure 1).
 - a. Release the wire harness on Feeder 4 from the clamps.
 - b. Remove the rear mounting screws (2).
 - c. Remove the front mounting screw and bracket.
 - d. Rotate Feeder 4 counter-clockwise to access the 3 P/J's and disconnect them, then remove Feeder 4.

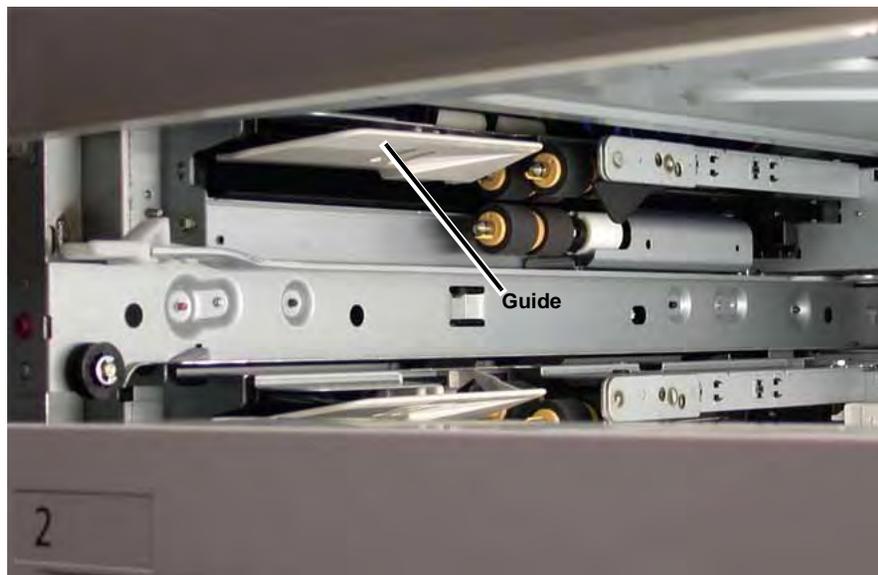
Figure 1 Guide

1. Remove the Paper Tray [REP 7.1](#).
2. Slide the guide to the front ([Figure 1](#)).

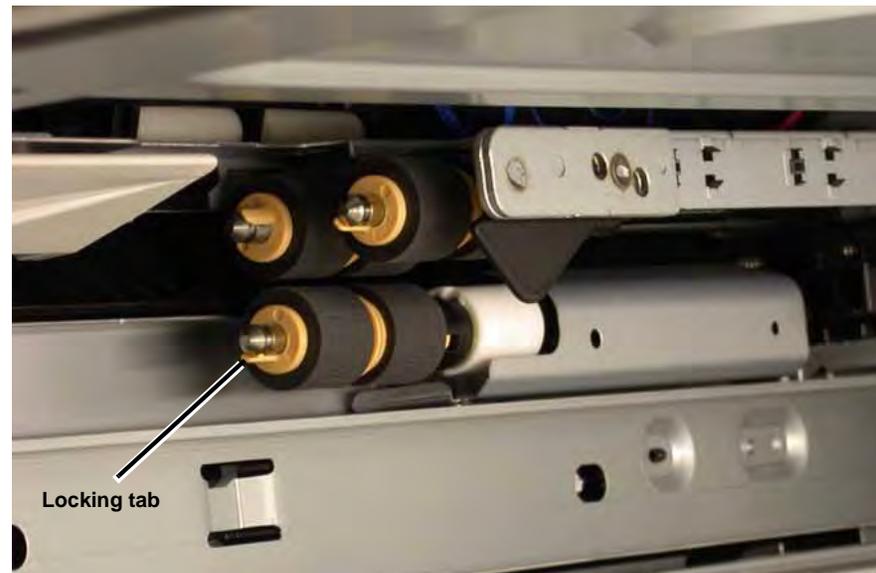
Figure 2 Removal

3. Remove the Feed, Nudger, and Retard Rolls (3) ([Figure 2](#)).
 - a. Release the locking tab and slide the roll off the shaft.

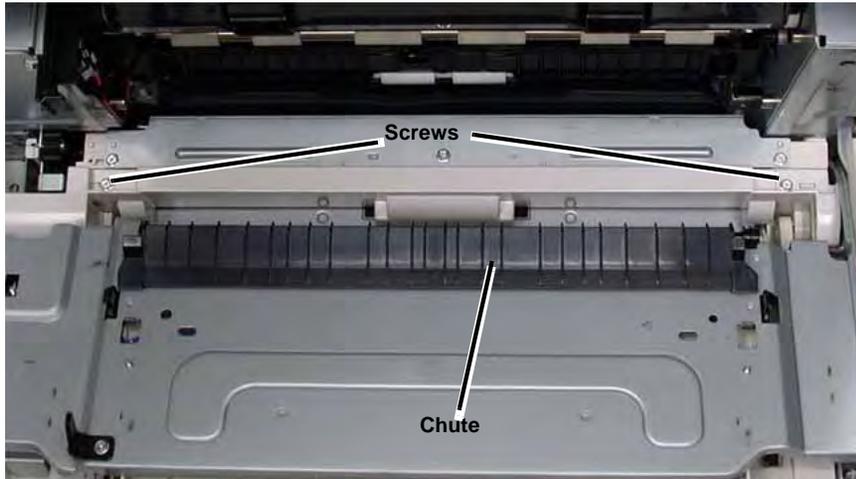
Figure 1 Removing Screws

1. Switch off the power and disconnect the power cord.
2. Open the Left Hand Cover. and perform the following ([Figure 1](#)).
 - a. Remove the Duplex Lower Chute.
 - b. Remove the screws (2) and the MSI Top Cover.

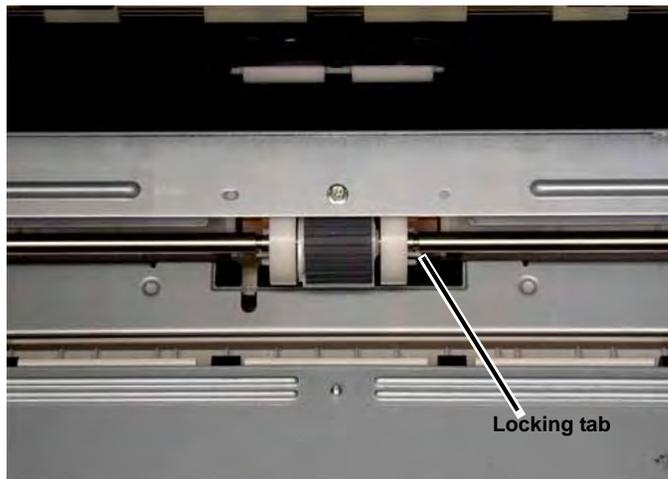
Figure 2 Roll

3. Release the Core Roll locking tab from the shaft and slide it to the front ([Figure 2](#)).

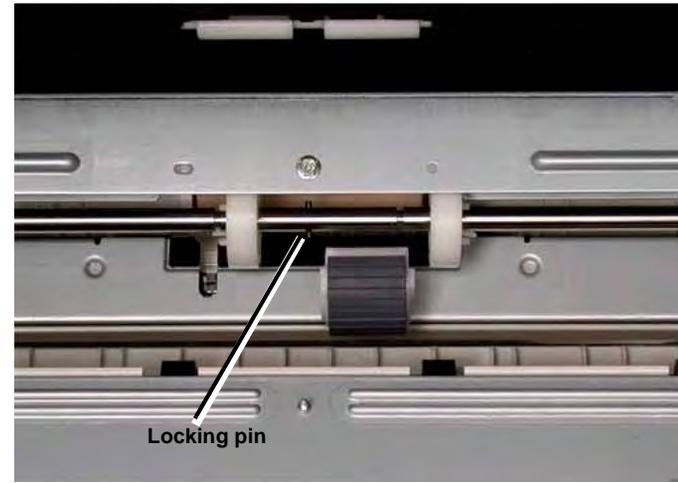
Figure 3 Removal

4. Slide the Feed Roll to the front, to clear the locating pin, and remove it ([Figure 3](#)).

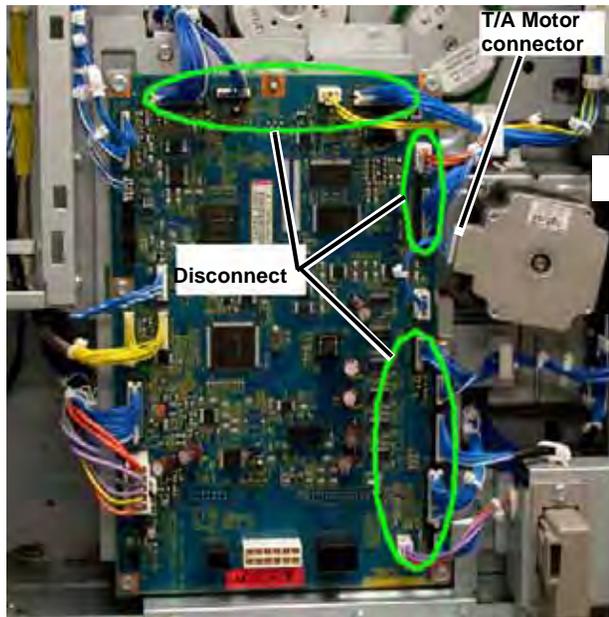
Figure 1 P/Js

1. Switch off the power and disconnect the power cord.
2. Remove the MSI Assembly [REP 7.2](#).
3. Disconnect the following connectors ([Figure 1](#)).
 - a. Takeaway Motor connector.
 - b. MCU PWB top and right side connectors, and release the wires from the clamps.

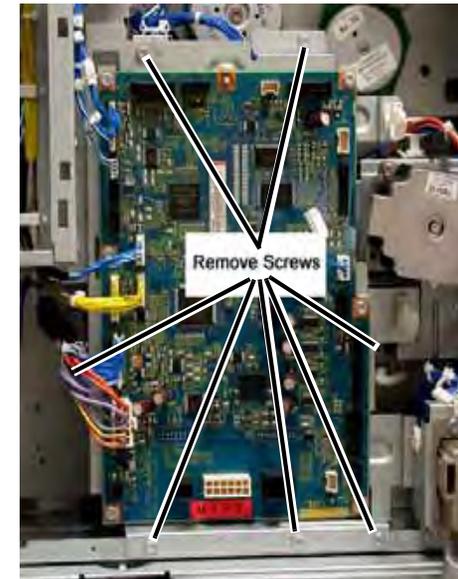
Figure 2 Removing Screws

4. Perform the following ([Figure 2](#))
 - a. Remove the MCU PWB chassis Screws (7).
 - b. Move the MCU PWB chassis to the left.

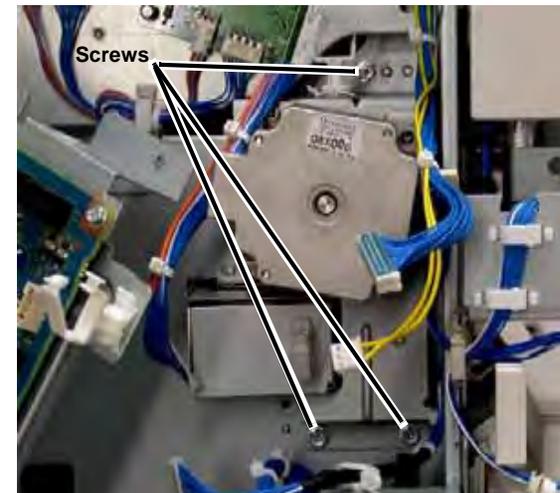
Figure 3 Removing Screws

5. Remove the Screws (3) and the Takeaway Motor ([Figure 3](#)).

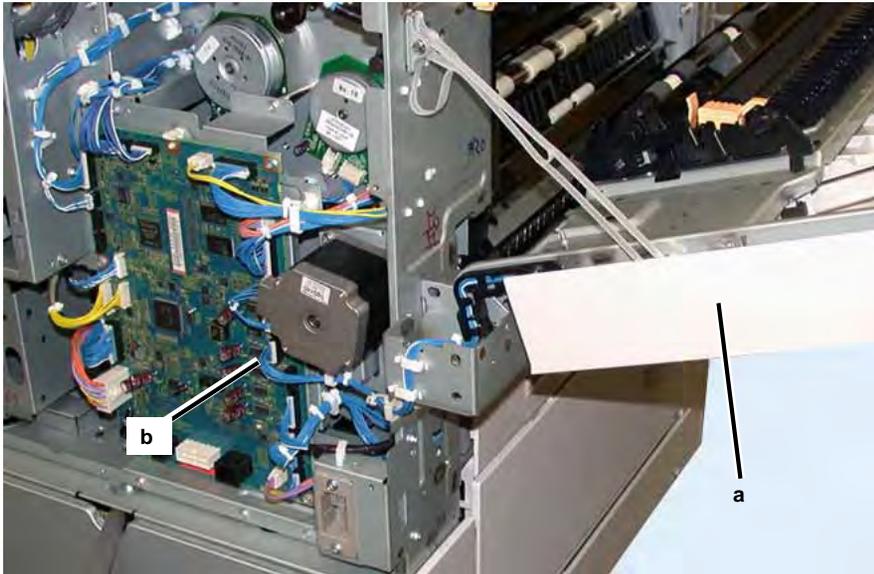
Figure 1 PJ

1. Switch off the power and disconnect the power cord.
2. Remove the MSI Assembly REP 7.2.
3. Perform the following (Figure 1).
 - a. Open the Left Hand Cover.
 - b. Disconnect PJ409 on the MCU PWB, and release the wire harness from the clamps

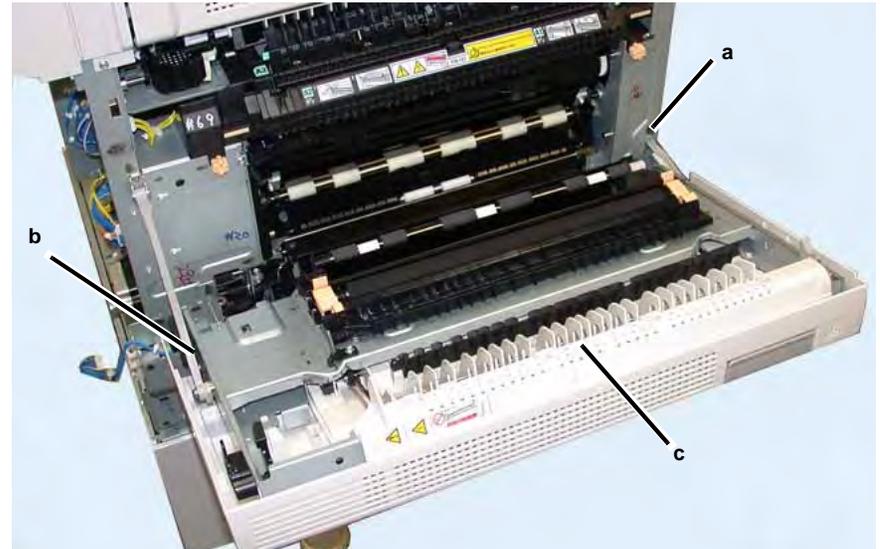
Figure 2 Left Hand Cover

NOTE: Support the Left Hand Cover Assembly when releasing the supports to prevent damaging the cover.

4. Remove the Left Hand Cover Assembly (Figure 2).
 - a. Twist the Front Support and remove it from the slot.
 - b. Remove the K-Clip, and remove the Rear Support from the pin.
 - c. Move the cover down to a horizontal position, then lift it off the pivots.

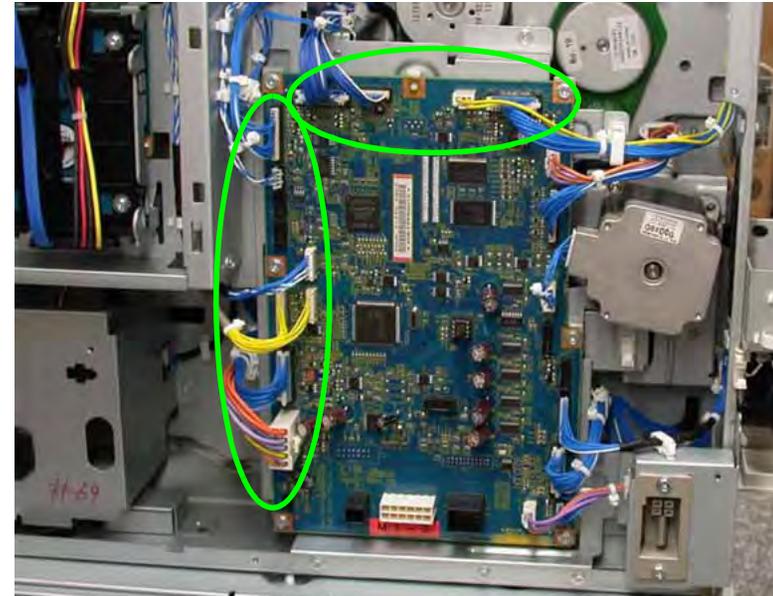
Figure 3 PJ's

5. Disconnect the connectors on the Top and Right side of the MCU PWB, and release the wire harnesses from the clamps (Figure 3).

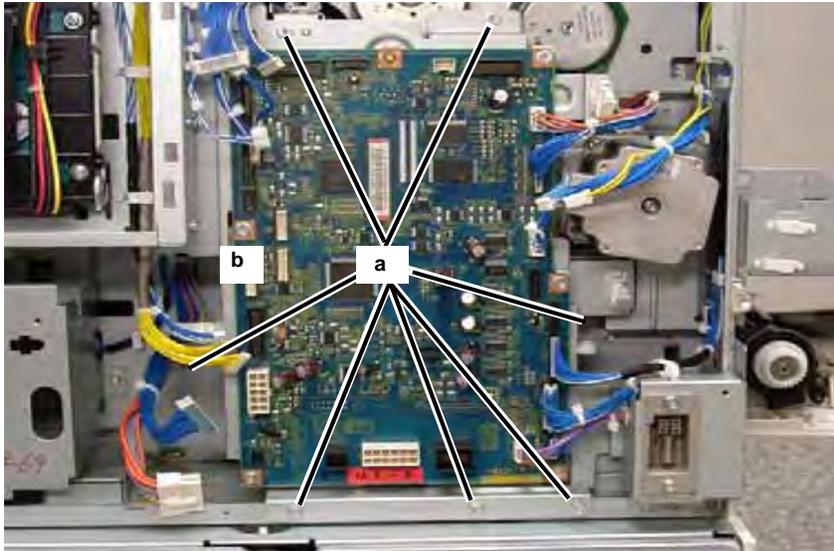
Figure 4 Removing Screws

6. Perform the following (Figure 4).
 - a. Remove the MCU PWB Bracket Screws (7)
 - b. Pivot the MCU PWB Bracket to the left.

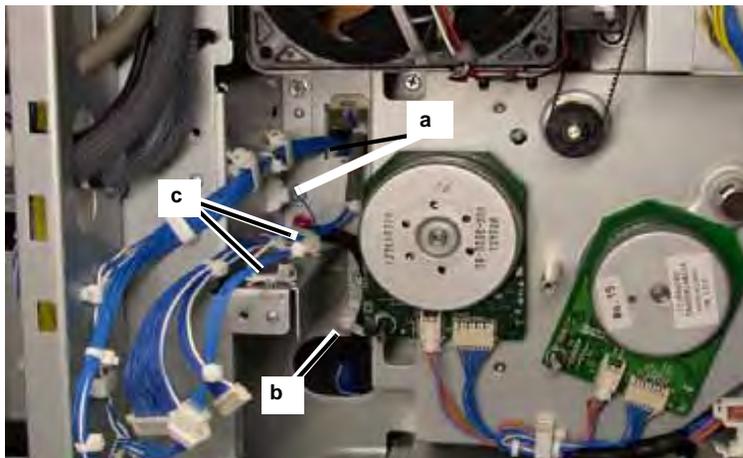
Figure 5 Wire Harness

7. Perform the following (Figure 5).
 - a. Disconnect PJ609.
 - b. Remove harness clamp from the rear frame.
 - c. Release the wire harness from the clamps.

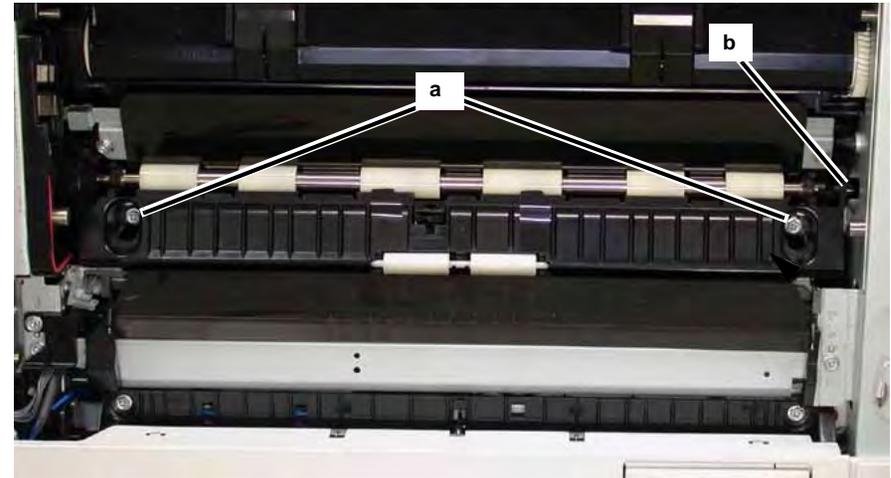
Figure 6 Removing Screws

NOTE: Support the Registration Transport when removing it to avoid damaging the wire harness connectors.

8. Remove the Registration Transport (Figure 6).
 - a. Remove the Screws (2)
 - b. Move the Front of the transport out of the slot and remove the transport.

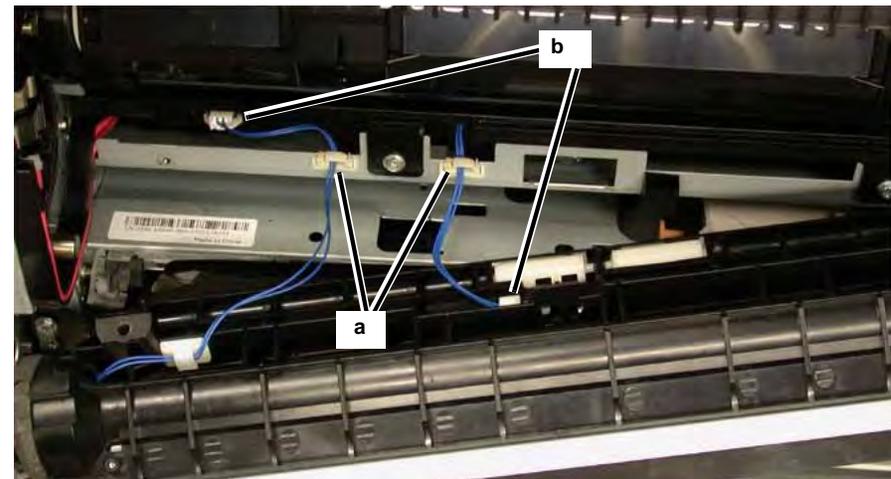
Figure 7 PJ's

9. Perform the following (Figure 7).
 - a. Release the wires from the clamps.
 - b. Disconnect the Registration Transport PJ's (2).

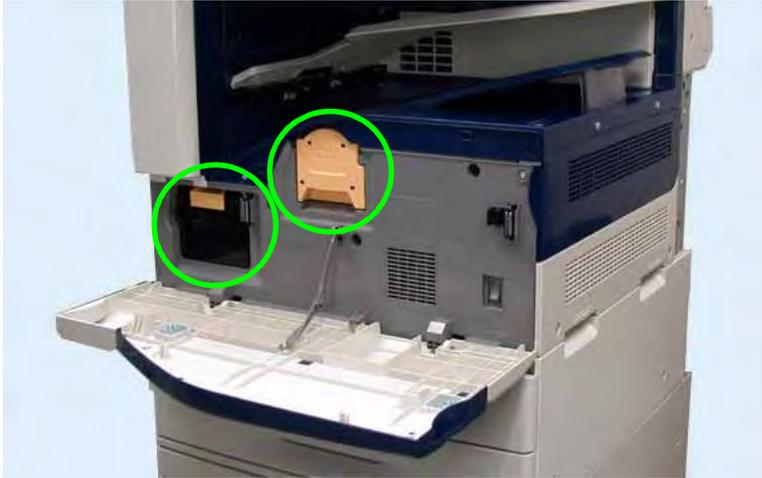
Figure 8 Removals

10. Open the Front Cover, remove the Xerographic Cartridge and the Toner Cartridge (Figure 8).

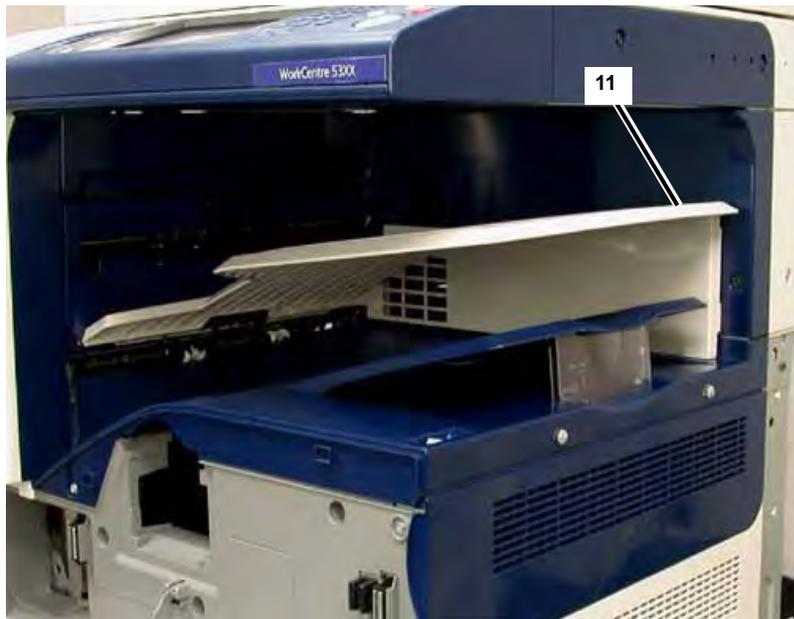
Figure 9 Removing Tray

11. Remove the Exit 2 Tray, release the Rear Locking Tab and remove the tray (Figure 9).

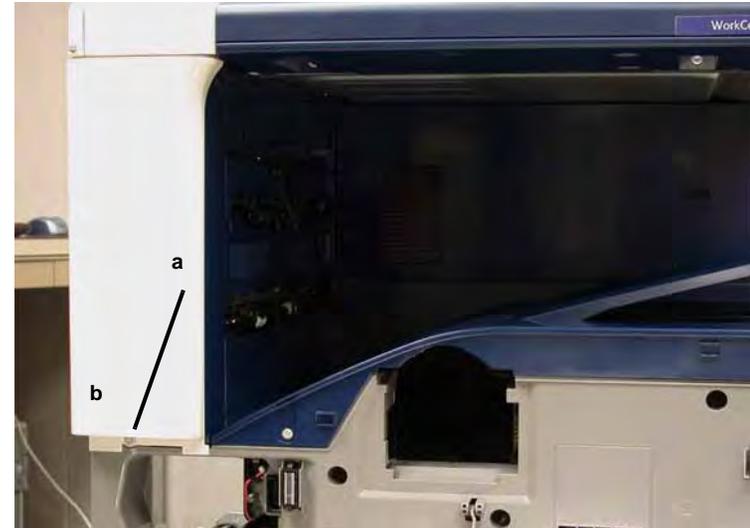
Figure 10 Removing Cover

12. Remove the Front Left Cover and Exit Front Cover (Figure 10).
- a. Remove Screw (1)
 - b. Pull out the bottom of the Front Left Cover and remove the covers.

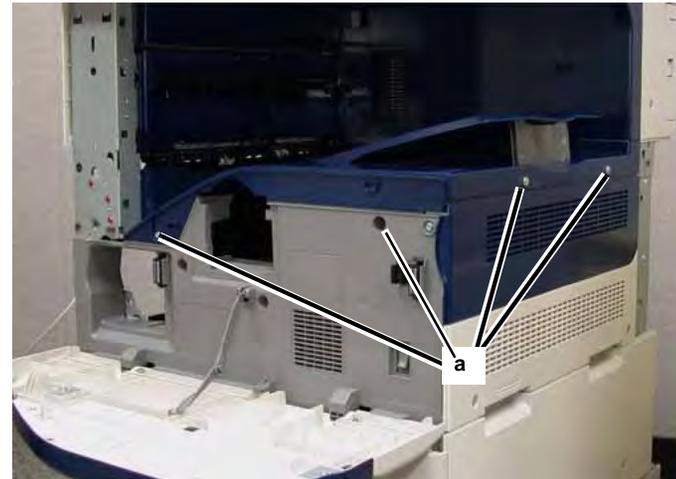
Figure 11 Removing Screws

13. Remove the Top Cover (Figure 11).
- a. Remove the Screws (4).
 - b. Lift the cover up and remove it.

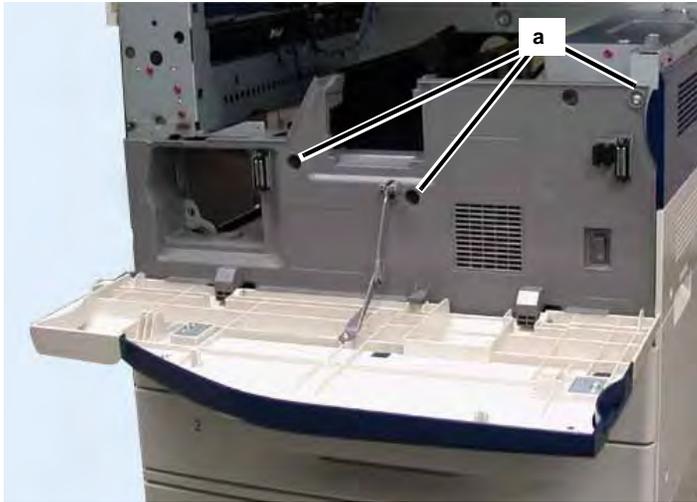
Figure 12 Removing Screws

14. Remove the Front Cover (Figure 12).
 - a. Remove the Screws (3).
 - b. Pull the top of the cover out and lift it off.

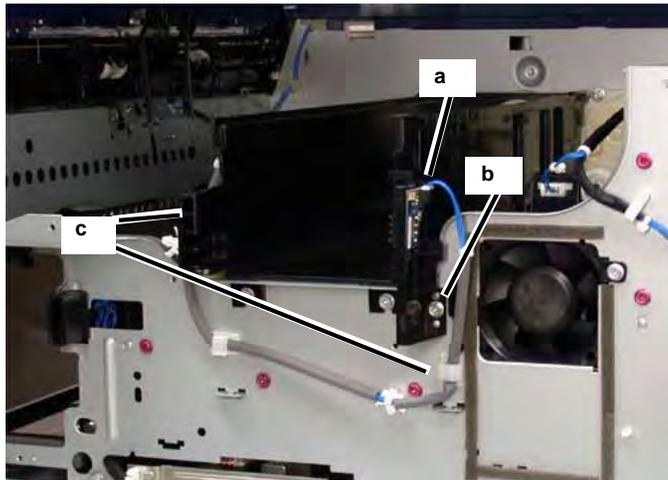
Figure 13 Wires & PJ

15. Remove the Toner Cartridge Connector (Figure 13).
 - a. Disconnect the PJ (1).
 - b. Remove Connector (1 Screw).
 - c. Release the wire harness from the front clamps and left side of the Cartridge Guide.

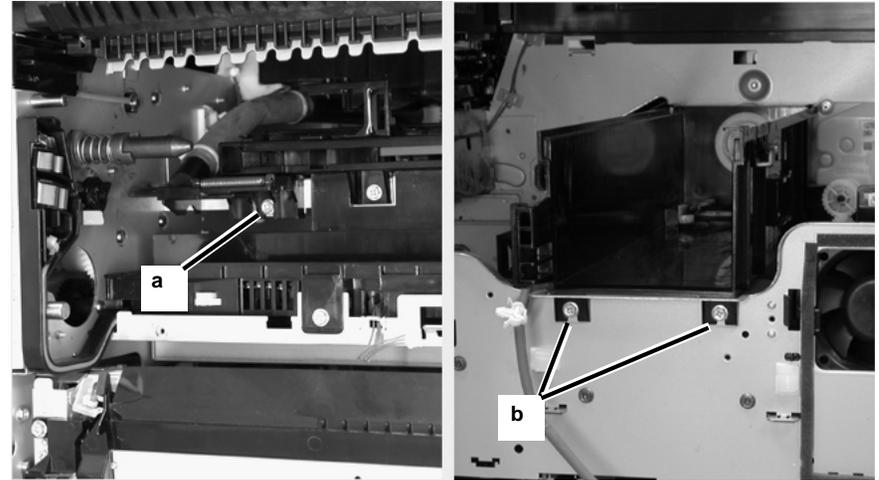
Figure 14 Removing Screws

16. Remove the Toner Cartridge Guide (Figure 14).
 - a. On the left rear, remove the Dispenser Tube Screw (1).
 - b. Loosen the front Screws (2).
 - c. Lift the front of the guide up and remove the guide.

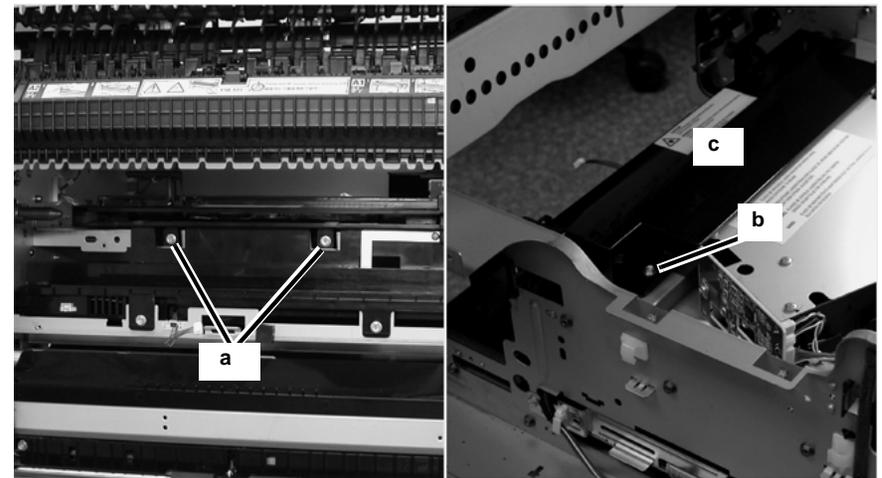
Figure 15 Removing The Cover

17. Remove the ROS Cover (Figure 15).
 - a. Remove the Screws (2) on the left side of the cover.
 - b. Remove the top Screw (1).
 - c. Move the cover to the left and remove it.

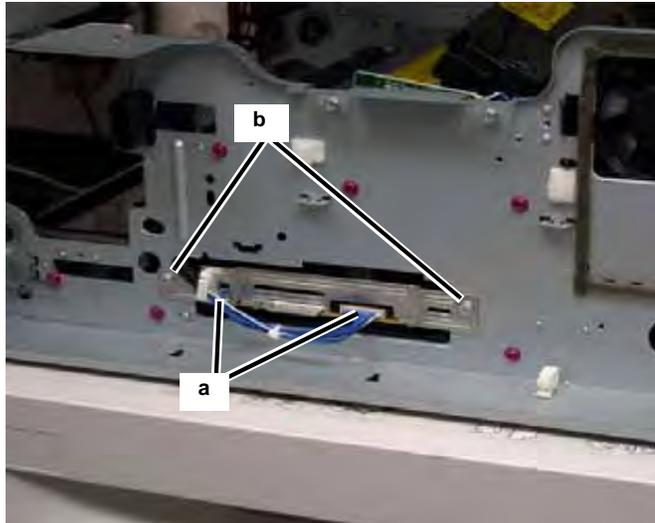
Figure 16 Removing Screws

18. Remove the HVPS (Figure 16).
 - a. Release the wire harness from the clamp, and disconnect the connector.
 - b. Remove the Screws (2).
 - c. Pull the HVPS out.

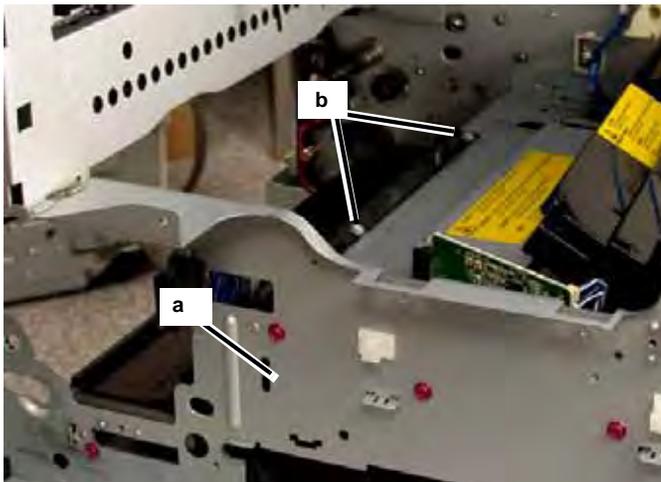
Figure 17 Removing Screws

19. Perform the following (Figure 17).
 - a. Release the Xerographic Module Connector from the frame.
 - b. Remove the Cartridge Guide top Screws (2).

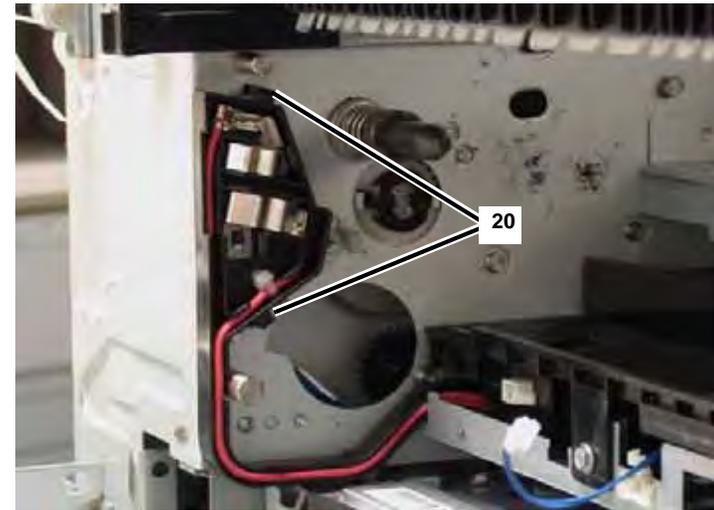
Figure 18 Removal

20. Release the BTR Contact Cover from the frame (2 locking tabs) (Figure 18).

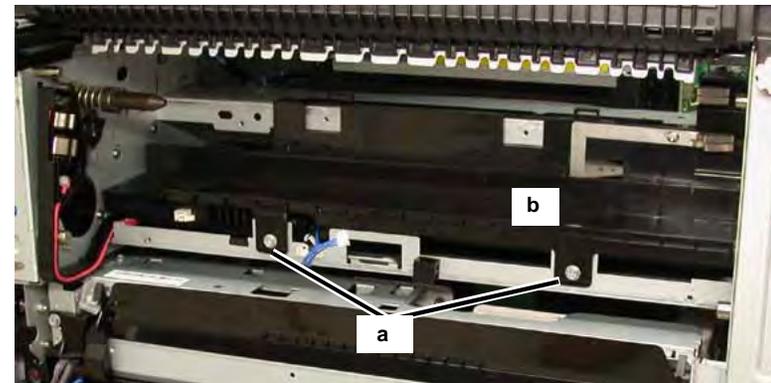
Figure 19 Removing Screws

21. Remove the Xerographic Cartridge Guide Assembly (Figure 19).
 - a. Remove the left side Screws (2).
 - b. Remove the guide, routing the front and rear wire harnesses through the frame openings.

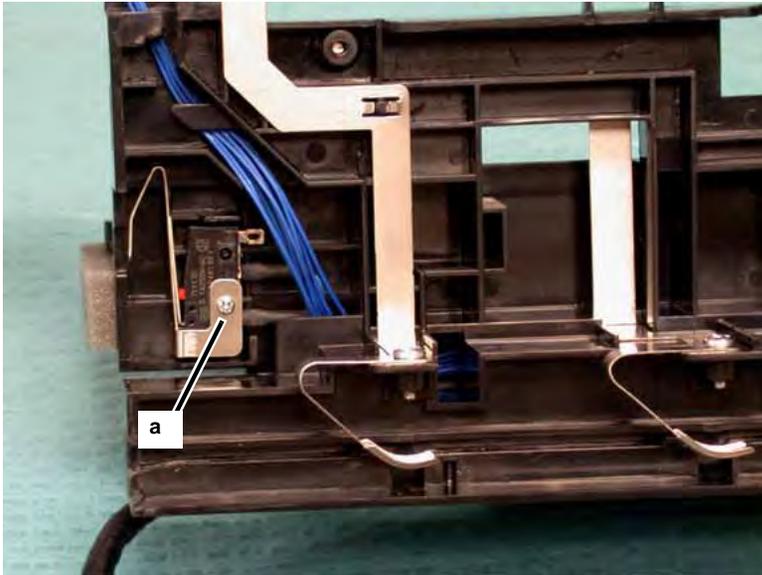
1. Switch off the power and disconnect the power cord.
2. Remove the Cartridge Guide [REP 9.1](#).
3. Remove the Xerographic Interlock Switch ([Figure 1](#)).
 - a. Remove the Screw (1)
 - b. Remove the switch and wire harness.

Figure 1 Removing Screw

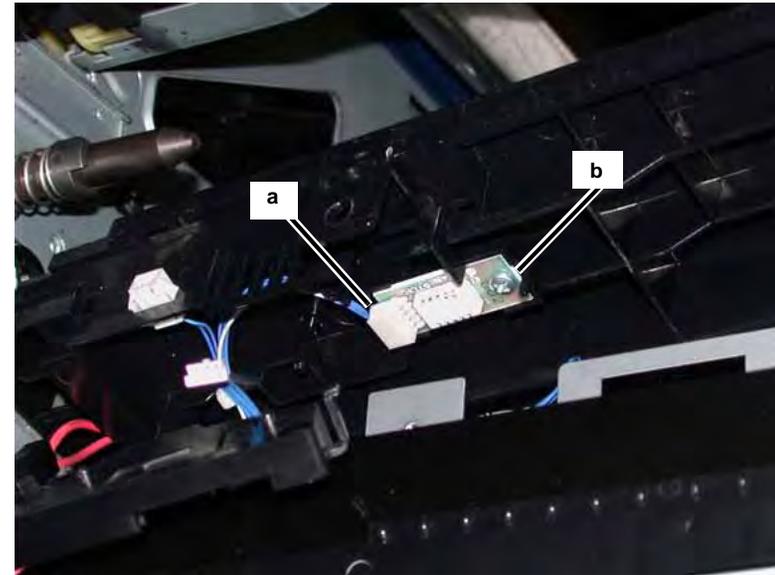
2. Remove the Xerographic Cartridge Guide [REP 9.1](#).
3. Remove the Humidity / Temperature Sensor ([Figure 1](#)).
 - a. Disconnect the connector.
 - b. Remove the Screw (1).

Figure 1 Removal

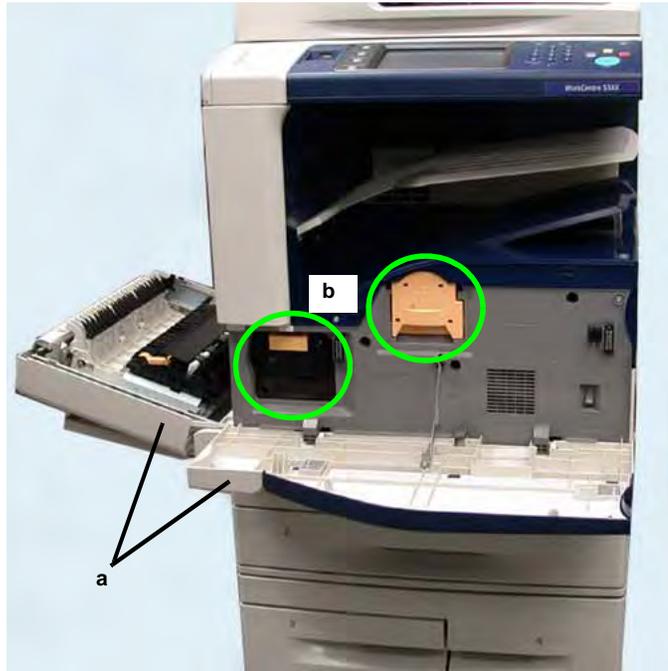
1. Switch off the power and disconnect the power cord.
2. Perform the following (Figure 1).
 - a. Open the Front Cover and the Left Hand Cover.
 - b. Remove the Xerographic Cartridge and the Toner Cartridge.

Figure 1 Removals

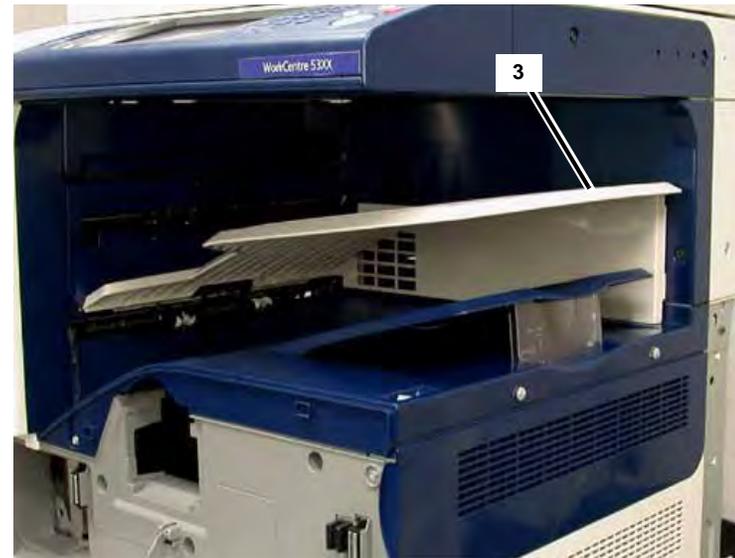
3. Remove the Exit 2 Tray, release the Rear Locking Tab and remove the tray (Figure 2).

Figure 2 Removing Tray

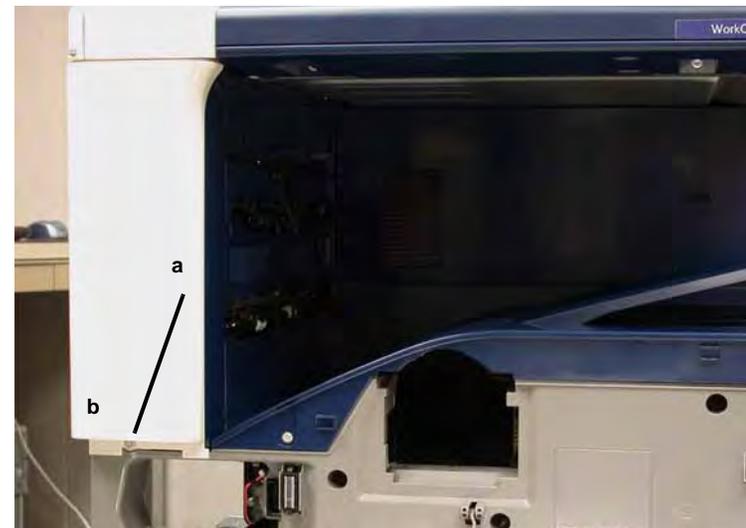
4. Remove the Front Left Cover and Exit Front Cover (Figure 3).
 - a. Remove the Screw (1).
 - b. Pull out the bottom of the Front Left Cover and remove the covers.

Figure 3 Removing Covers

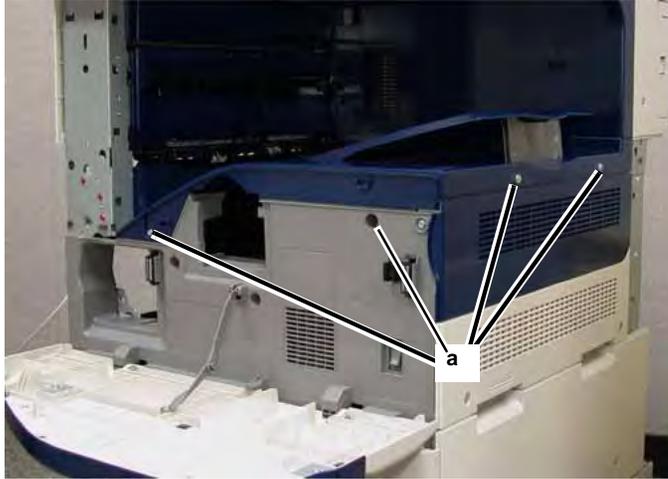
5. Remove the Top Cover (Figure 4).
 - a. Remove the Screws (4).
 - b. Lift the cover up and remove it.

Figure 4 Removing Screws

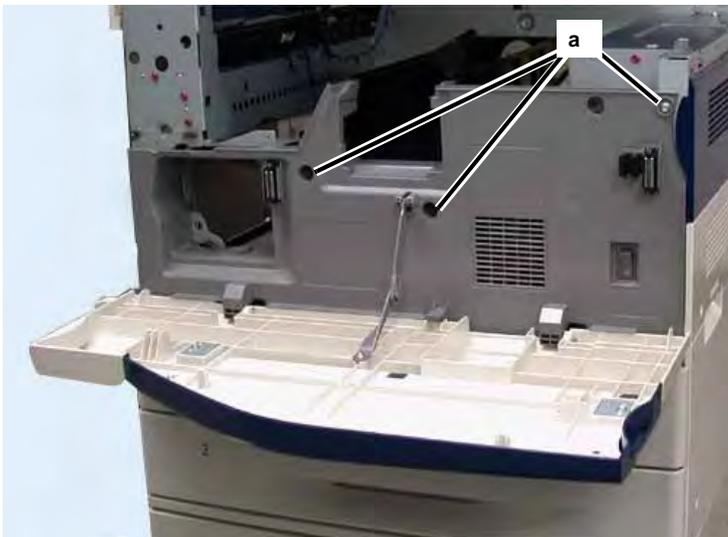
6. Remove the Front Cover (Figure 5).
 - a. Remove the Screws (3).
 - b. Pull the top of the cover out and lift it off.

Figure 5 Removing Screws

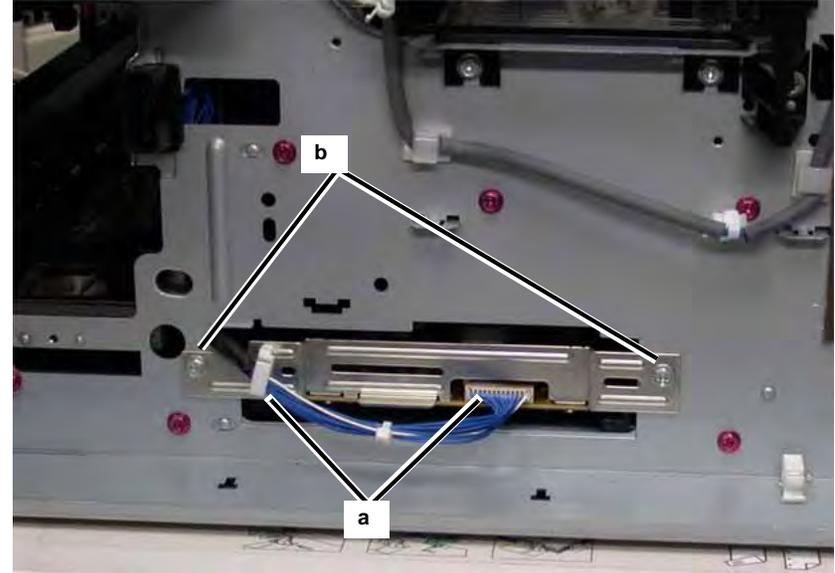
7. Remove the HVPS (Figure 6).
 - a. Release the wire harness from the clamp and disconnect the connector.
 - b. Remove the Screws (2) and pull the HVPS out.

Figure 6 Removing The HVPS

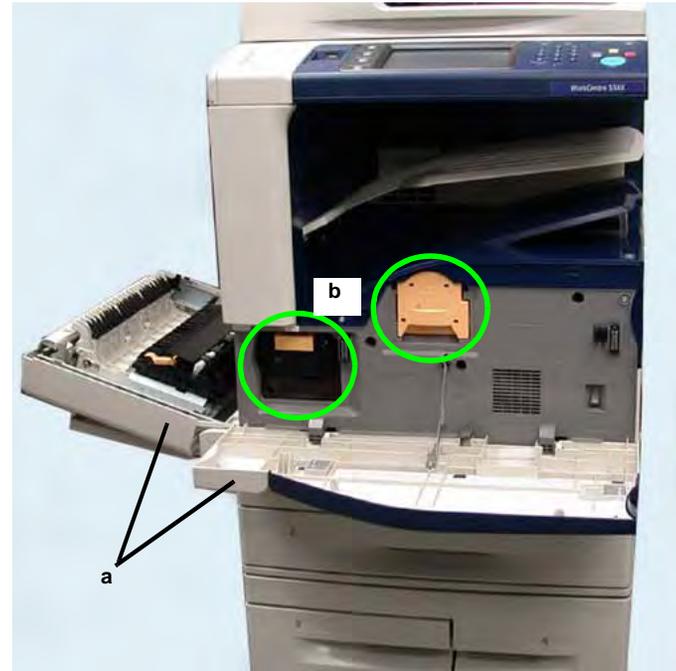
1. Switch off the power and disconnect the power cord.
2. Perform the following ([Figure 1](#)).
 - a. Open the Front Cover and the Left Hand Cover.
 - b. Remove the Xerographic Cartridge and the Toner Cartridge.

Figure 1 Removals

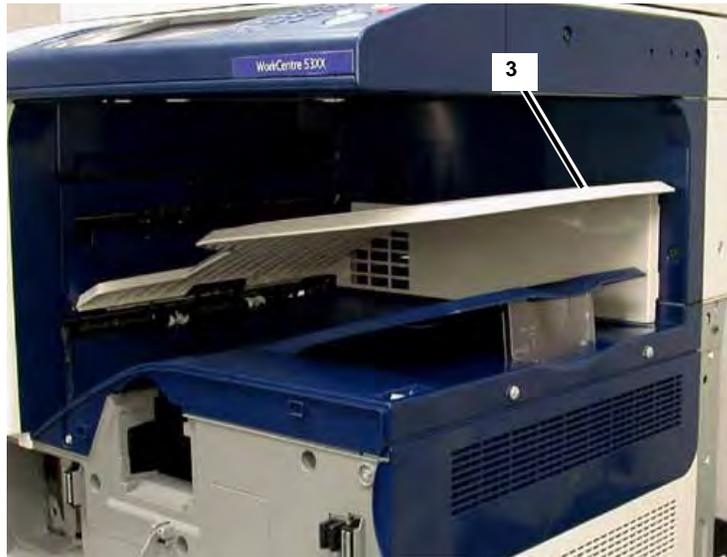
3. Remove the Exit 2 Tray, release the Rear Locking Tab and remove the tray (Figure 2).

Figure 2 Removing Tray

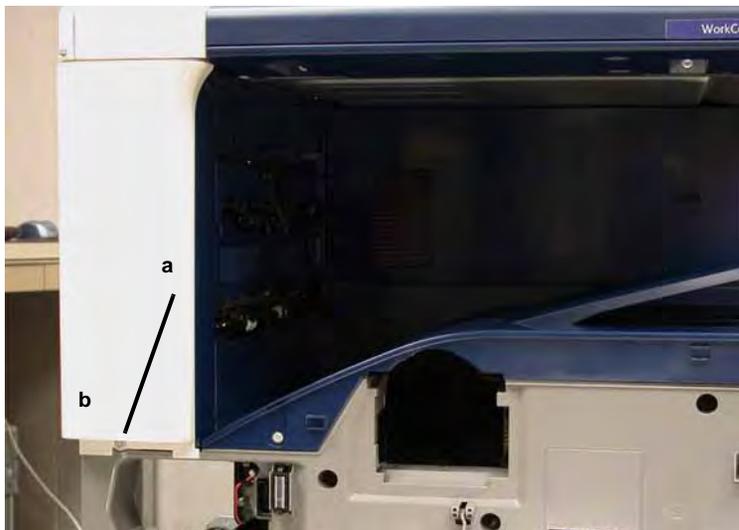
4. Remove the Front Left Cover and Exit Front Cover (Figure 3).
 - a. Remove Screw (1).
 - b. Pull out the bottom of the Front Left Cover and remove the covers.

Figure 3 Removing Covers

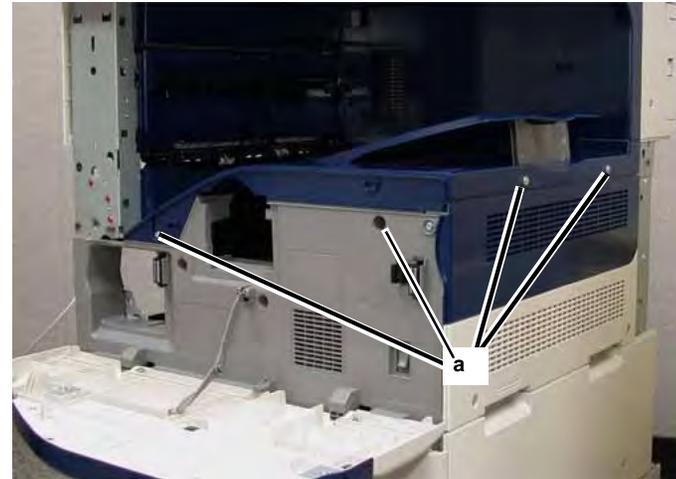
5. Remove the Top Cover (Figure 4).
 - a. Remove the Screws (4).
 - b. Lift the cover up and remove it.

Figure 4 Removing Screws

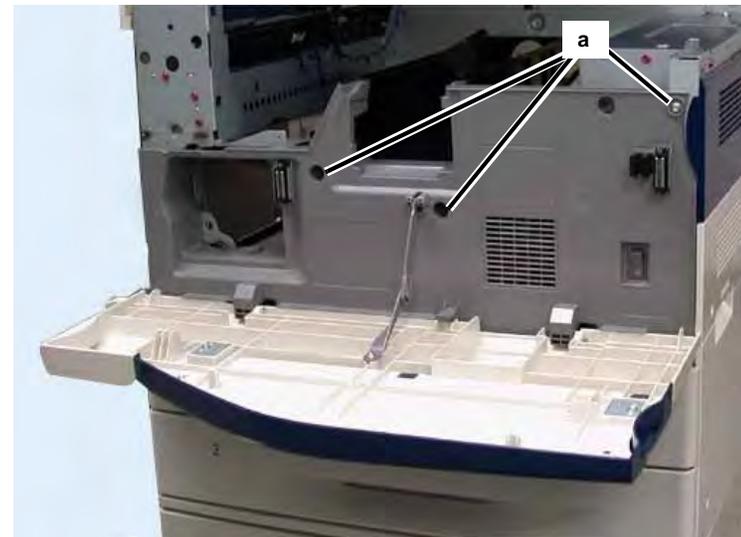
6. Remove the Front Cover (Figure 5).
 - a. Remove the Screws (3).
 - b. Pull the top of the cover out and lift it off.

Figure 5 Removing Screws

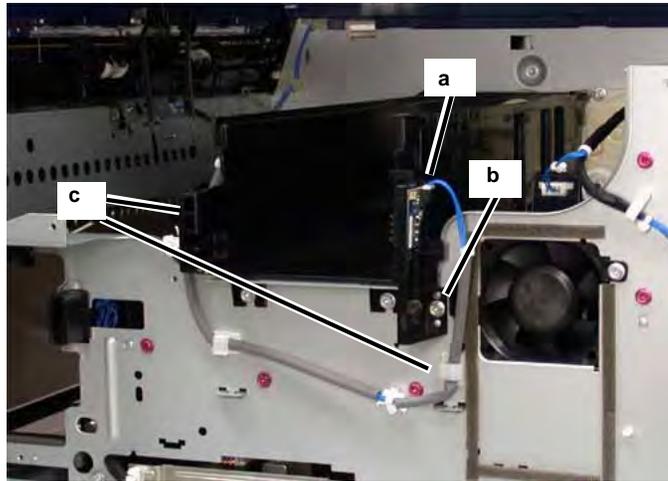
7. Remove the Toner Cartridge Connector (Figure 6).
 - a. Disconnect the PJ (1).
 - b. Remove Connector (1 Screw).
 - c. Release the wire harness from the front clamps and left side of the Cartridge Guide.

Figure 6 Wires & PJ
