WorkCentre 5335 Family Service Documentation

705P01303

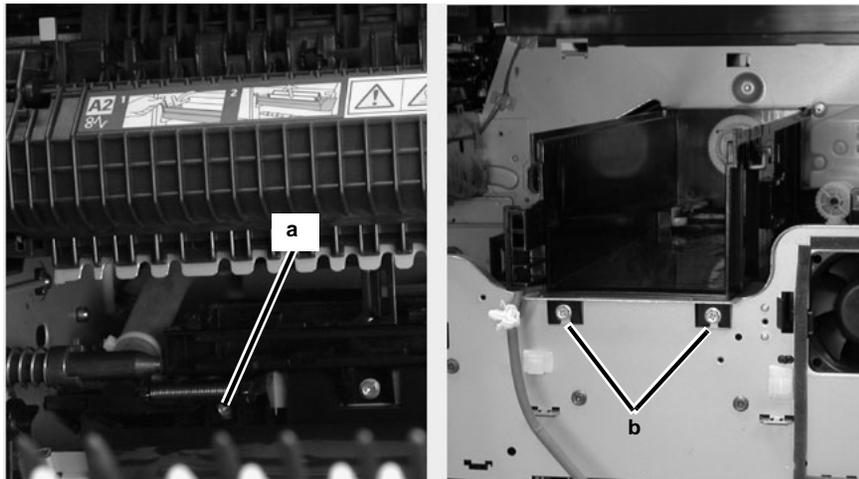
8. Remove the Toner Cartridge Guide (Figure 7).
 - a. On the left rear of the guide, remove the Dispenser Tube Screw (1).
 - b. Loosen the front Screws (2).
 - c. Lift the front of the guide up and remove it.

Figure 7 Removing The Screws

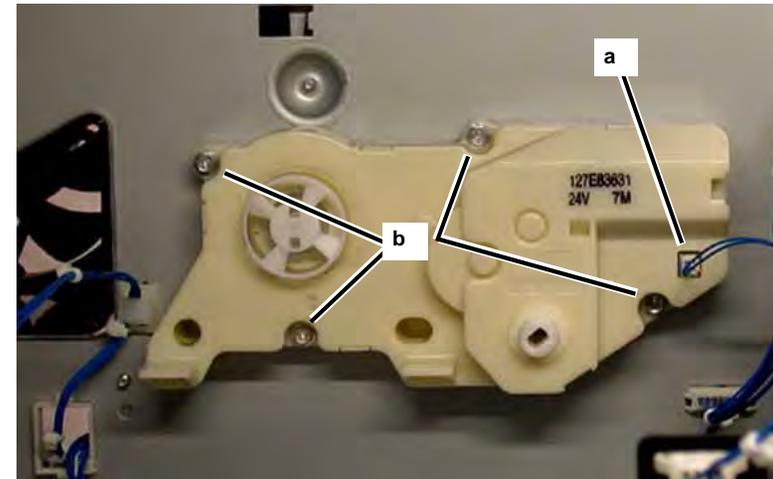
9. Remove the Toner Dispense Motor (Figure 8).

NOTE: The 4 motor screws are longer than the other screws, keep them with the motor for reinstallation.

- a. Disconnect the PJ (1).
- b. Remove the Screws (4), and the Motor.

Figure 8 Removing The Motor

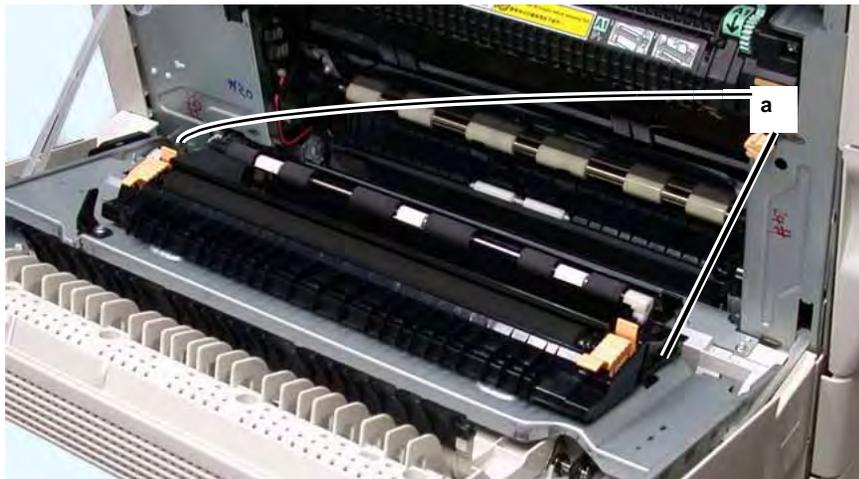
1. Switch off the power and disconnect the power cord.
2. Open the Left Hand Cover (Figure 1).
 - a. Release the front and rear locking tabs and remove the BTR Assembly.

Figure 1 Removal

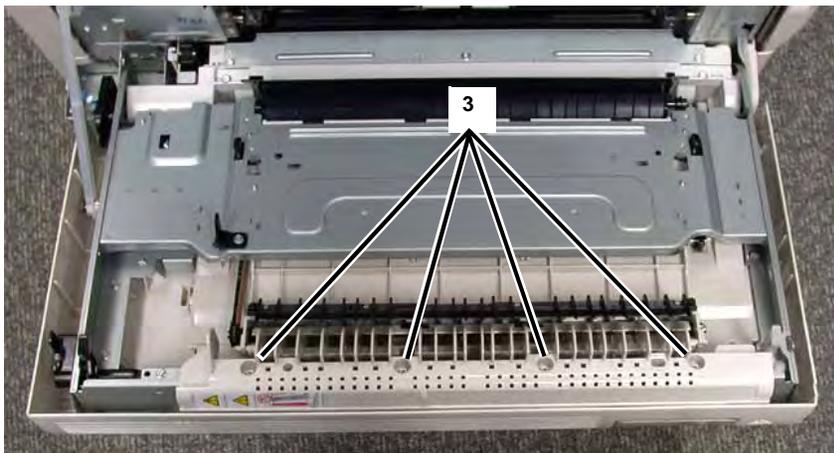
3. Remove the Left Hand Chute Cover (4 Screws) (Figure 2).

Figure 2 Removing Screws

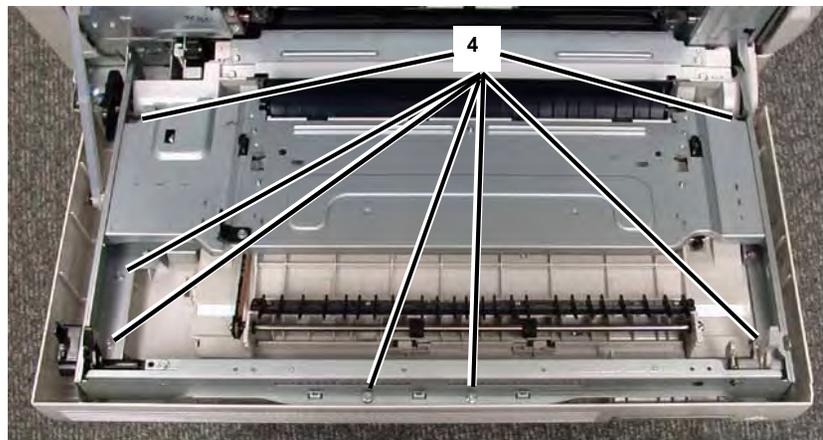
4. Remove the Left Hand Cover (7 Screws) (Figure 3).

NOTE: The Left Hand Cover Screws have a different thread than the other screws, keep them with the cover for re-installation.

Figure 3 Removing Screws

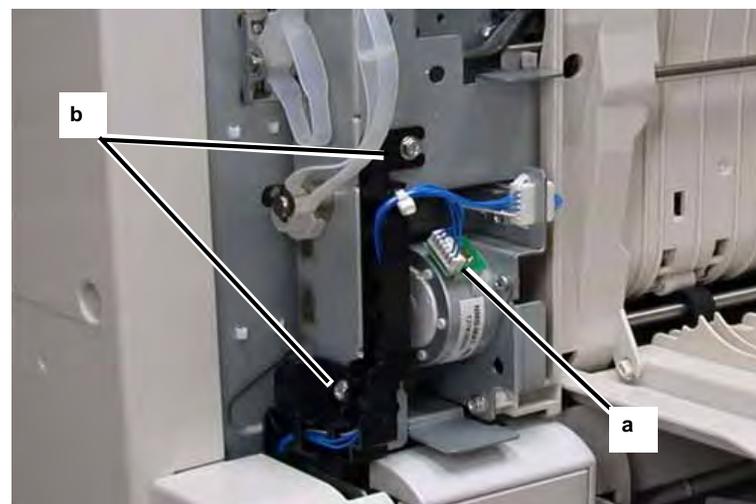
5. Perform the following (Figure 4).
 - a. Disconnect the PJ from the Duplex Motor.
 - b. Remove the Harness Guide; loosen the top screw, remove the bottom screw.

Figure 4 Removing Screws

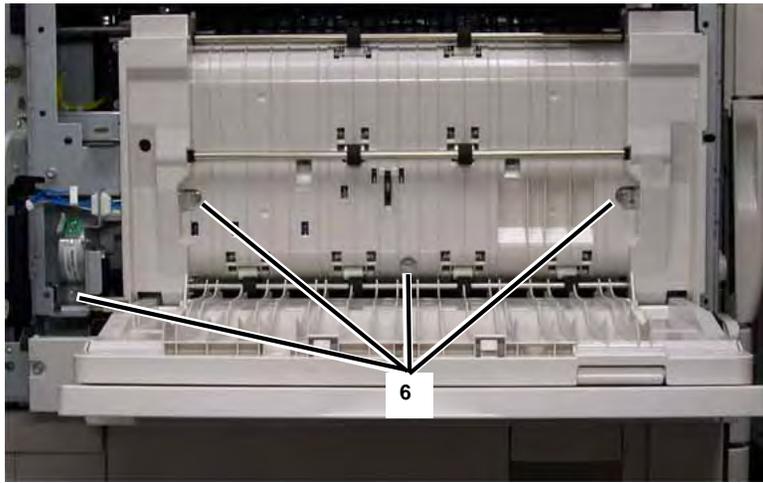
6. Remove the Duplex Assembly from the Left Hand Cover (4 Screws) (Figure 5).

Figure 5 Removing Screws

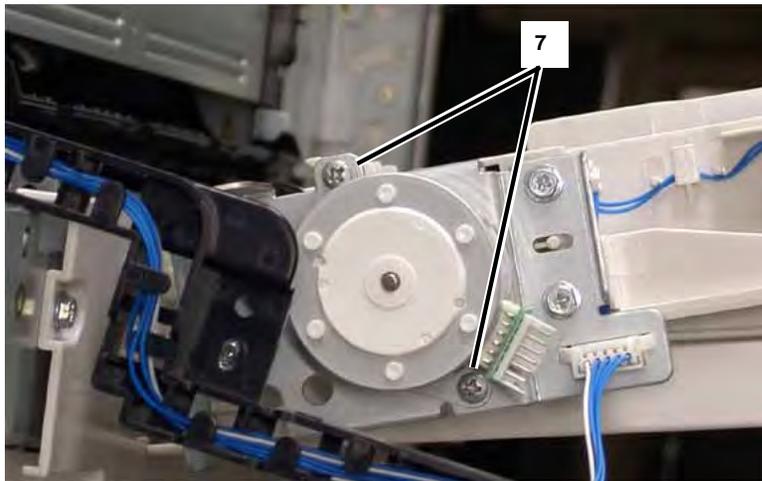
7. Remove the Duplex Motor (2 Screws) (Figure 6).

Figure 6 Removing Screws

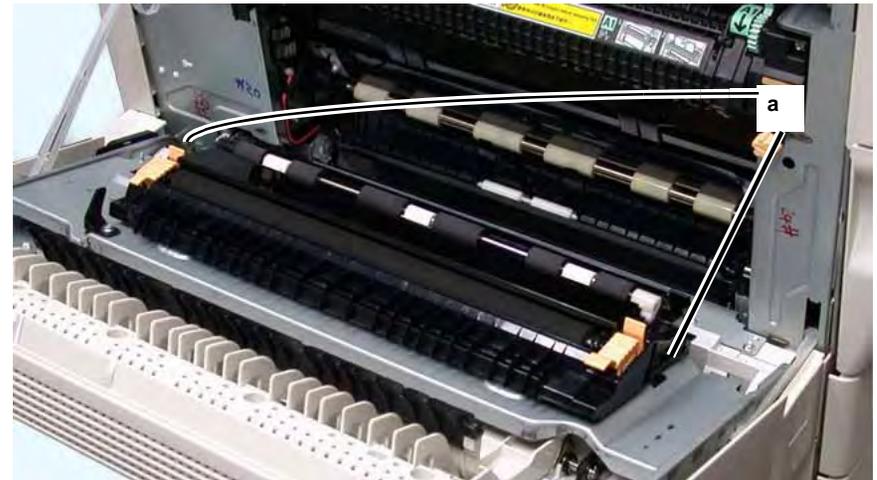
1. Switch off the power and disconnect the power cord.
2. Open the Left Hand Cover (Figure 1).
 - a. Release the front and rear locking tabs and remove the BTR Assembly.

Figure 1 Removal

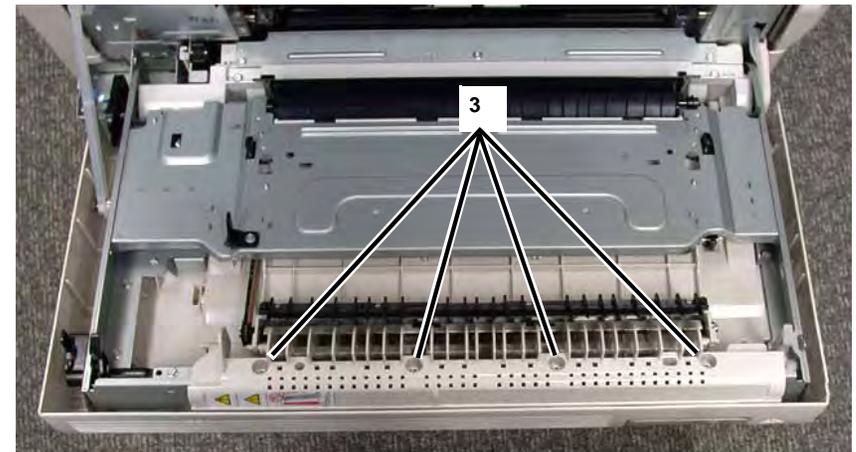
3. Remove the Left Hand Chute Cover (4 Screws) (Figure 2).

Figure 2 Removing Screws

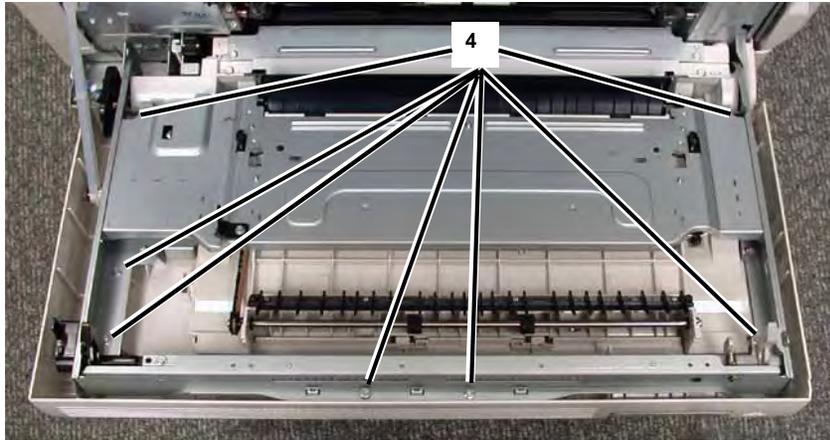
4. Remove the Left Hand Cover (7 Screws) (Figure 3).

NOTE: The Left Hand Cover Screws have a different thread than the other screws, keep them with the cover for re-installation.

Figure 3 Removing Screws

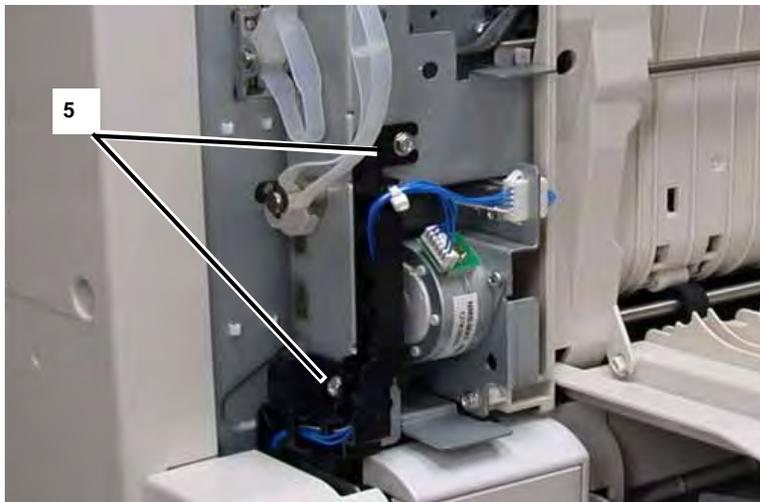
5. Remove the Harness Guide (Figure 4).
 - a. Loosen the top screw, remove the bottom screw.

Figure 4 Removing Screws

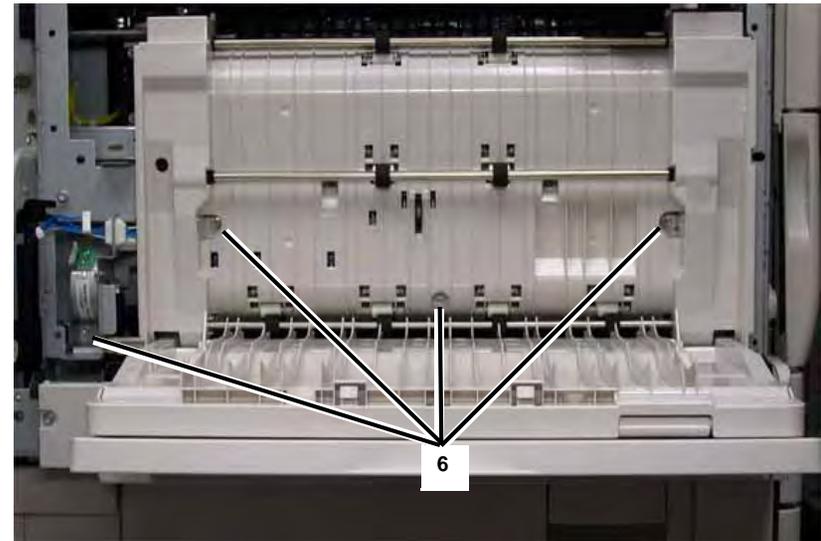
6. Remove the Duplex Assembly from the Left Hand Cover (4 Screws) (Figure 5).

Figure 5 Removing Screws

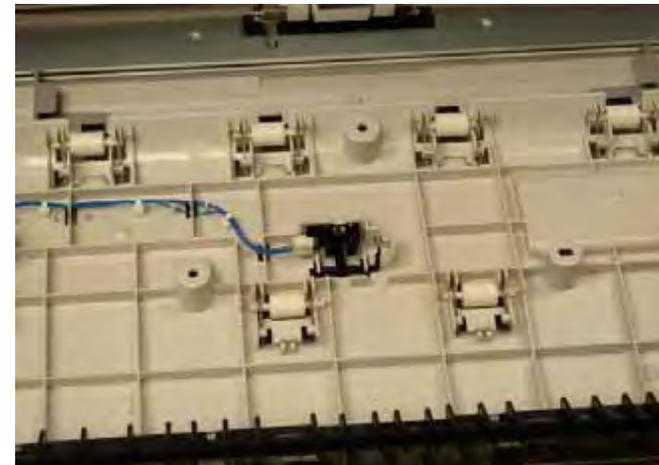
7. Remove the Duplex Sensor (Figure 6).

NOTE: Be careful not to damage or lose the Sensor Actuator Spring.

Figure 6 Duplex Sensor

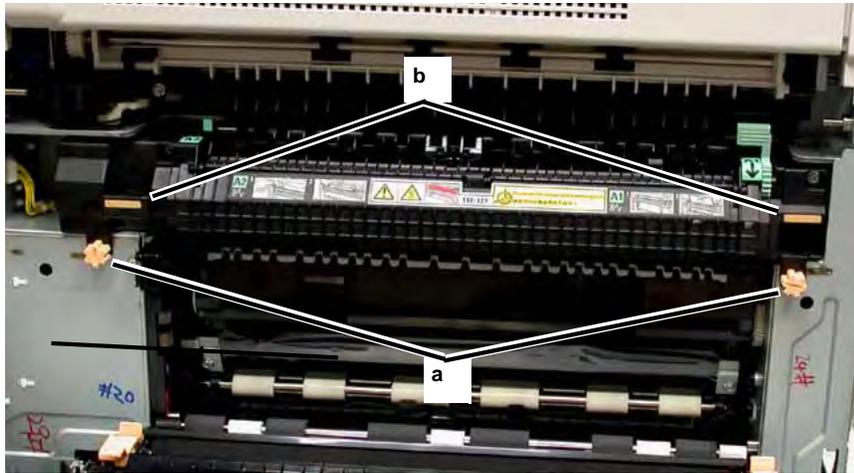
1. Switch off the power and disconnect the power cord.
2. Open the Left Hand Cover and remove the Fuser ([Figure 1](#)).
 - a. Loosen the knobs (2).
 - b. Hold the Fuser by the handles and remove it.

Figure 1 Removal

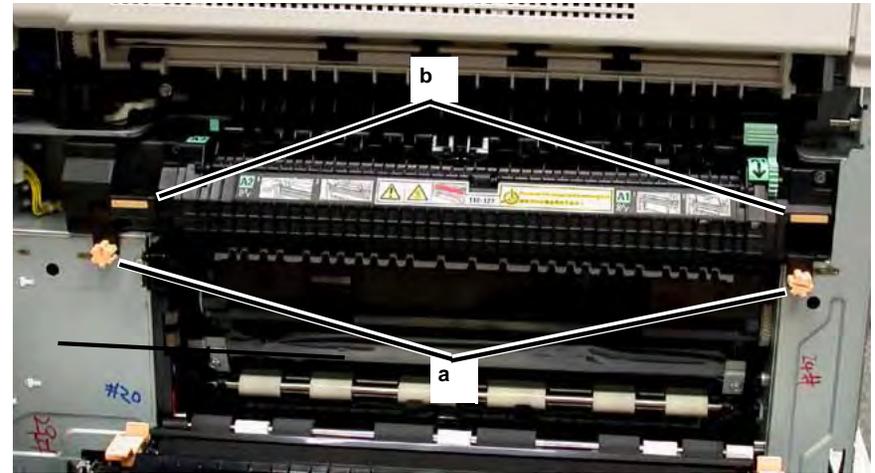
1. Switch off the power and disconnect the power cord.
2. Open the Left Hand Cover and remove the Fuser ([Figure 1](#)).
 - a. Loosen the knobs (2).
 - b. Hold the Fuser by the handles and remove it.

Figure 1 Removal

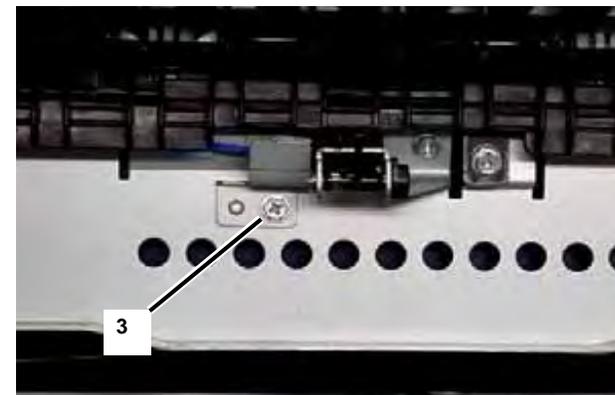
3. Remove the Plate (1 Screw) ([Figure 2](#)).

Figure 2 Removing Screw

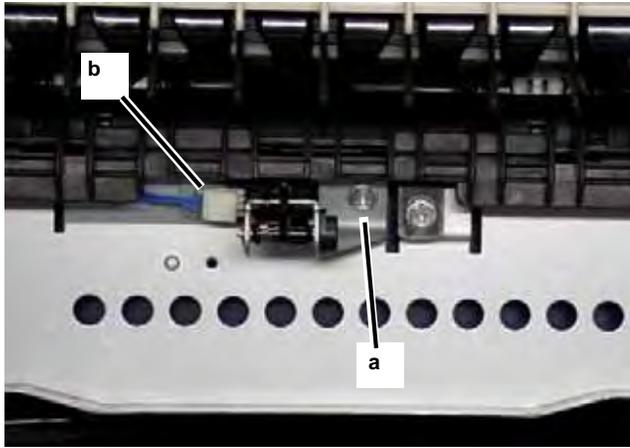
4. Remove the Exit Sensor Plate Assembly (Figure 3).
 - a. Remove the Screw (1).
 - b. Disconnect the connector.

Figure 3 Removing Screw

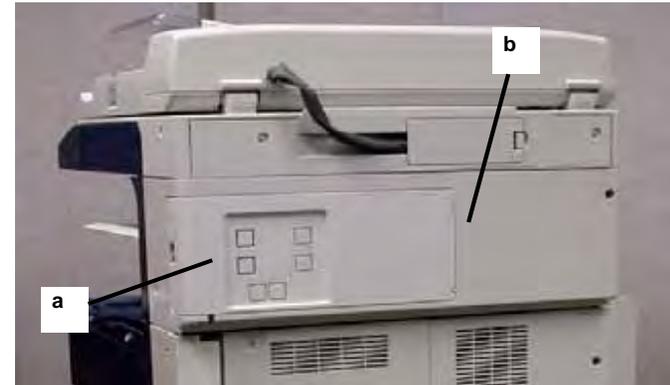
1. Switch off the power and disconnect the power cord.
2. Remove the following covers (Figure 1).
 - a. Fax Cover.
 - b. Rear Upper Cover (2 Screws).

Figure 1 Removing Covers

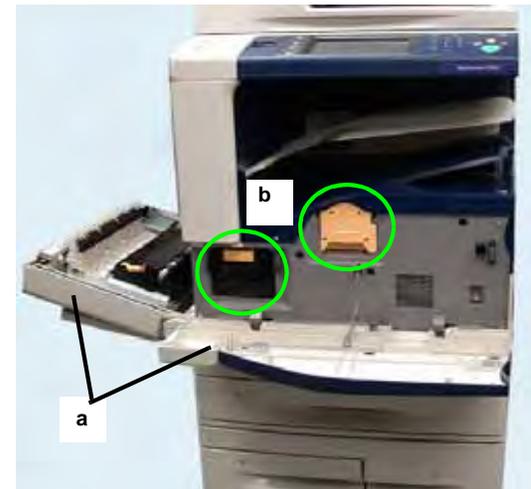
3. Perform the following (Figure 2).
 - a. Open the Front Cover and the Left Hand Cover.
 - b. Remove the Xerographic Cartridge and the Toner Cartridge.

Figure 2 Removals

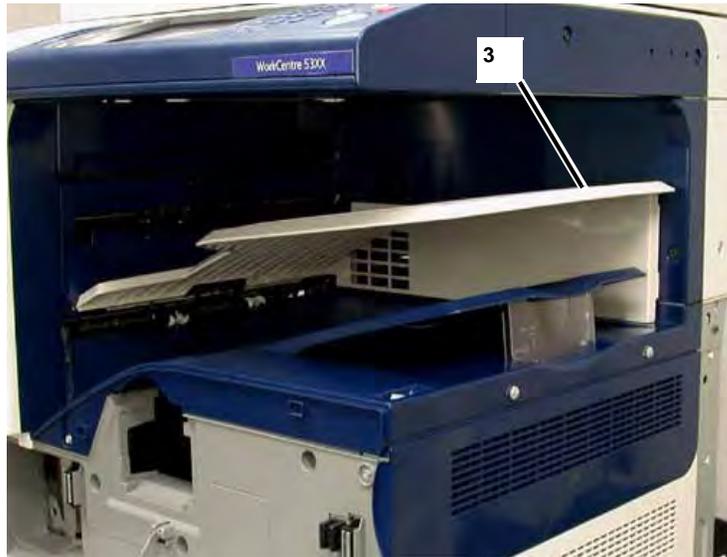
4. Remove the Exit 2 Tray, release the Rear Locking Tab and remove the tray (Figure 3).

Figure 3 Removing Tray

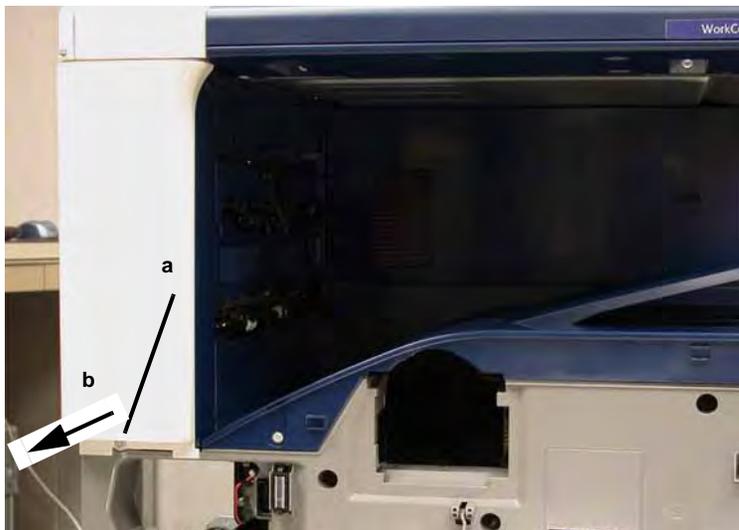
5. Remove the Front Left Cover and Exit Front Cover (Figure 4).
a. Remove Screw (1)
b. Pull out the bottom of the Front Left Cover and remove the covers.

Figure 4 Removing Covers

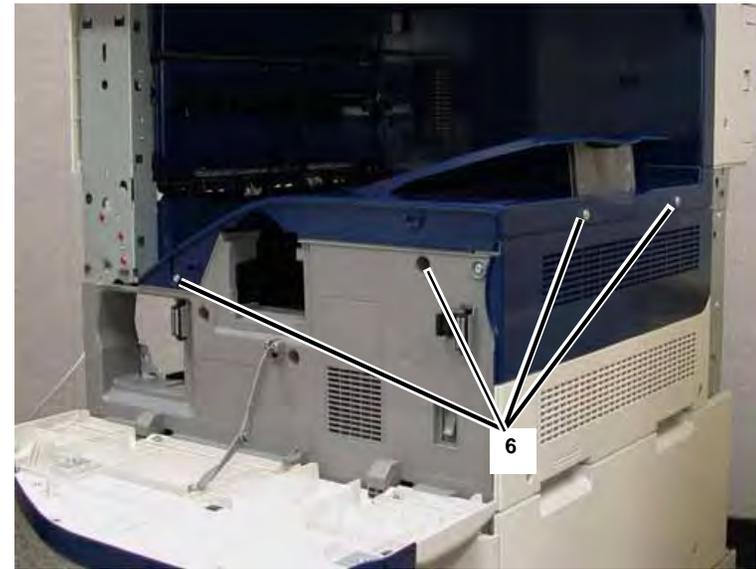
6. Remove the Top Cover Screws (4) (Figure 5).

Figure 5 Removing Screws

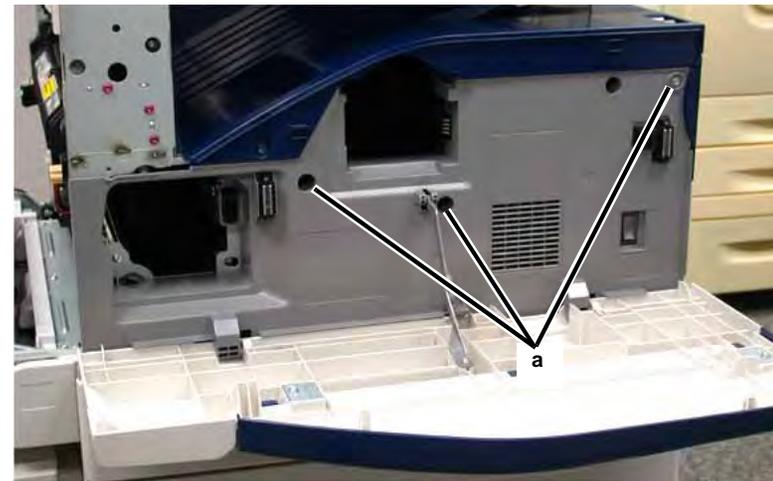
7. Remove the Front Cover (Figure 6).
a. Remove the Screws (3).
b. Raise the Top Cover, and pull the top of the Front Cover out and lift it off.

Figure 6 Removing Screws

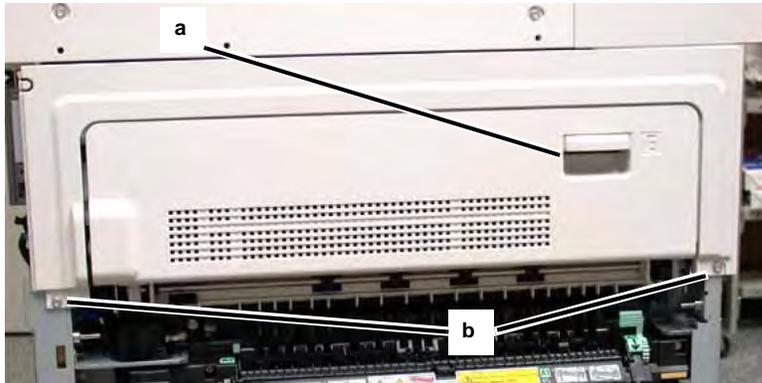
8. Remove the Left Upper Cover (Figure 7).
 - a. Open the Left Hand High Chute.
 - b. Remove the Screws (2) and Cover.

Figure 7 Removing Screws

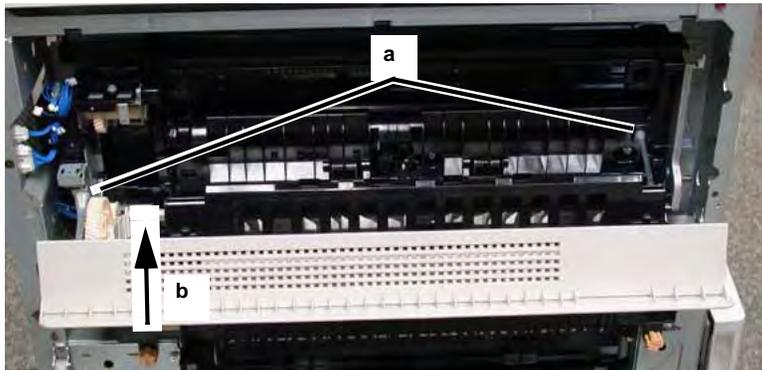
9. Remove the Left Hand High Chute (Figure 8).
 - a. Rotate the Front and Rear Stoppers 1/4 turn to release them from the brackets.
 - b. Lift the rear of the Chute and slide the front out of the pivot.

Figure 8 Removal

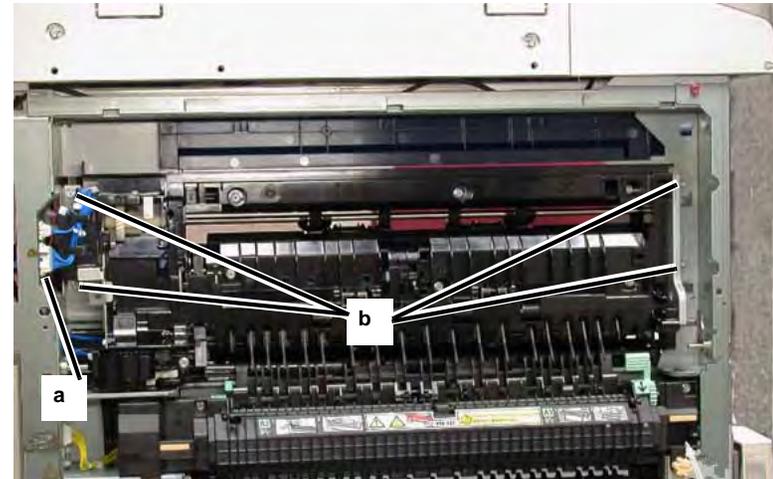
Figure 9 Removing Screws

10. Remove the Exit 2 Assembly (Figure 9).
 - a. Disconnect the PJ's (2).
 - b. Remove the screws (4), and remove the assembly.

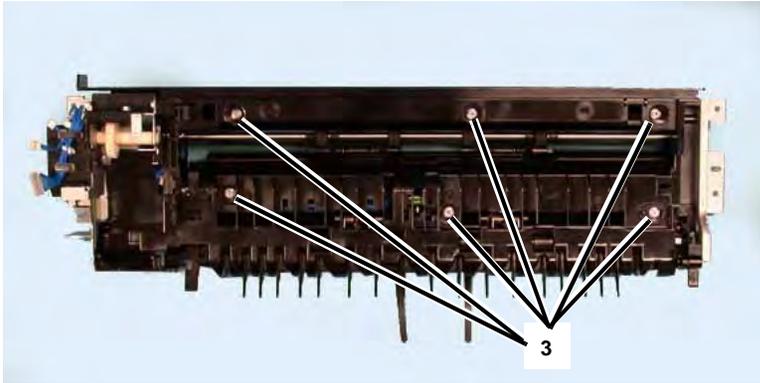
Figure 1 Removing Screws

1. Switch off the power and disconnect the power cord.
2. Remove the Exit 2 Assembly [REP 10.5](#).
3. Remove the screws (6) and the Exit 2 Guide Assembly ([Figure 1](#)).

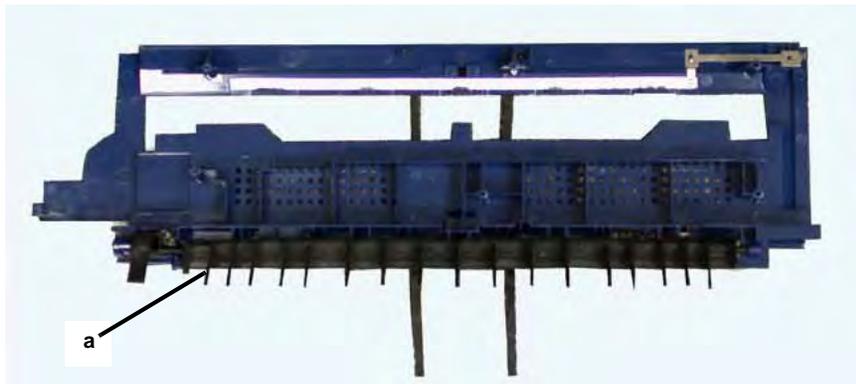
Figure 2 Exit Gate

4. Exit 2 Guide Assembly ([Figure 2](#)).
 - a. Exit Gate.

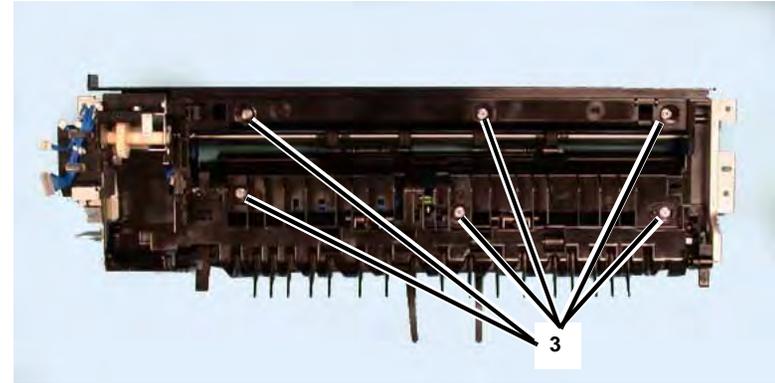
Figure 1 Removing Screws

1. Switch off the power and disconnect the power cord.
2. Remove the Exit 2 Assembly [REP 10.5](#).
3. Remove the screws (6) and the Exit 2 Guide Assembly ([Figure 1](#)).

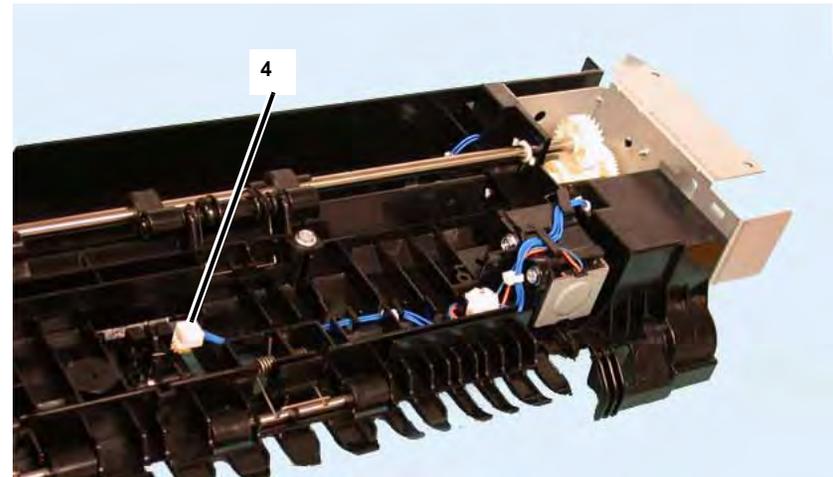
Figure 2 Exit 2 Sensor

4. Exit 2 Sensor removal, disconnect the PJ (1) and release the sensor from the assembly. ([Figure 2](#)).

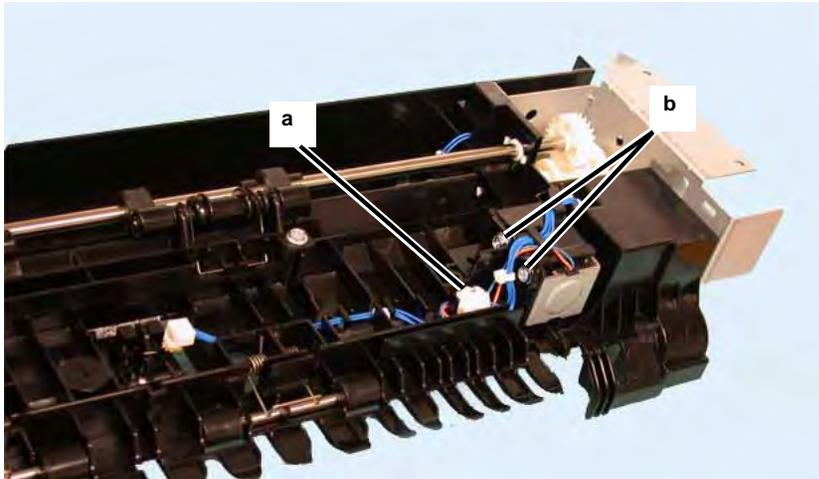
Figure 3 Removing Screws

5. Exit Gate Solenoid removal (Figure 3).
 - a. Disconnect the connector (1).
 - b. Remove the Screws (2), and the solenoid.

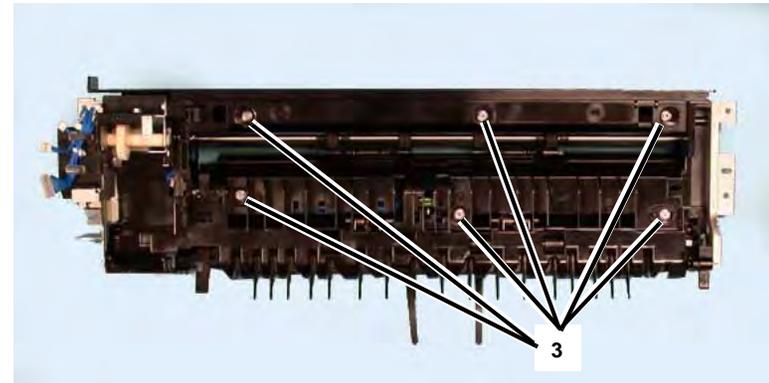
Figure 1 Removing Screws

1. Switch off the power and disconnect the power cord.
2. Remove the Exit 2 Assembly REP 10.5.
3. Remove the screws (6) and the Exit 2 Guide Assembly (Figure 1).

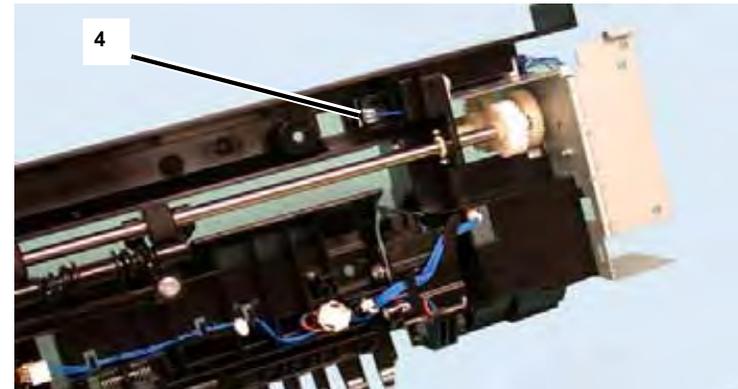
Figure 2 Removal

4. Left Hand Chute Interlock Switch removal; disconnect the connector, and release the sensor from the assembly (Figure 2).

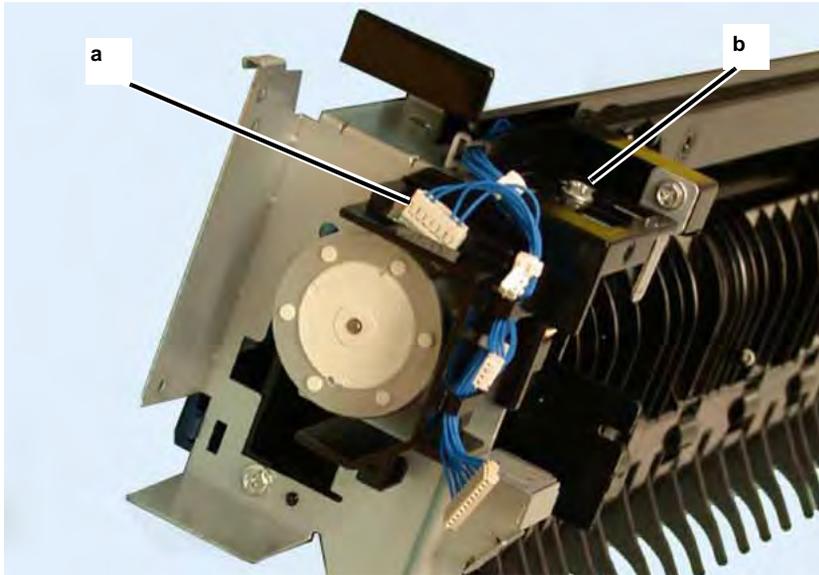
Figure 1 Removing Screw & PJ

1. Switch off the power and disconnect the power cord.
2. Remove the Exit 2 Assembly REP 10.5.
3. Perform the following (Figure 1).
 - a. Disconnect the motor PJ.
 - b. Remove the Rear Cover (1 Screw).

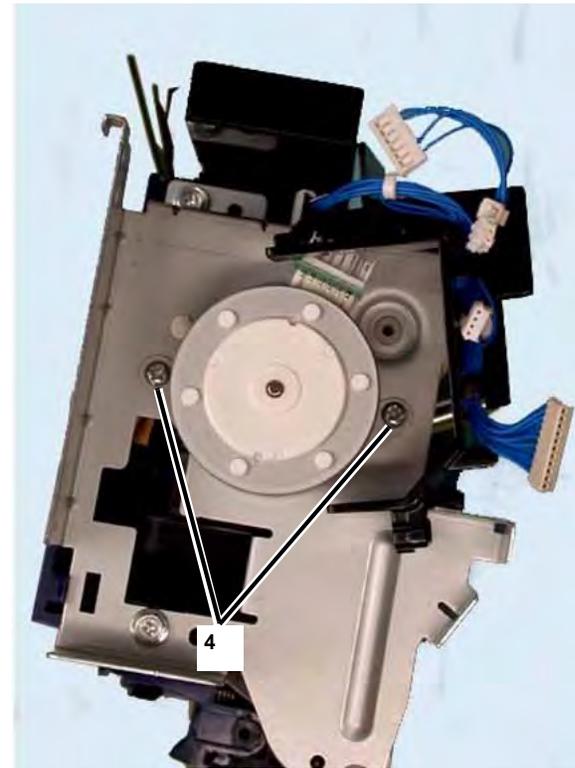
Figure 2 Removing Screws

4. Remove the Screws (2) and the Exit 2 Motor (Figure 2).

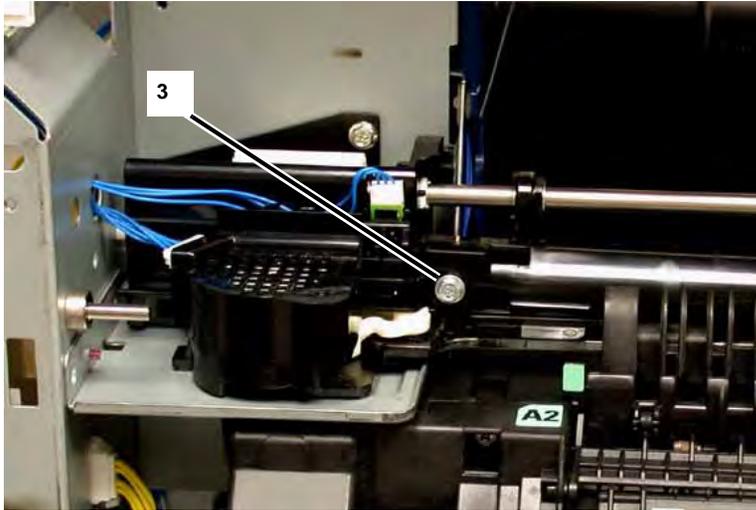
Figure 1 Removing Screw

3. Remove the Motor Cover (1 Screw) ([Figure 1](#)).

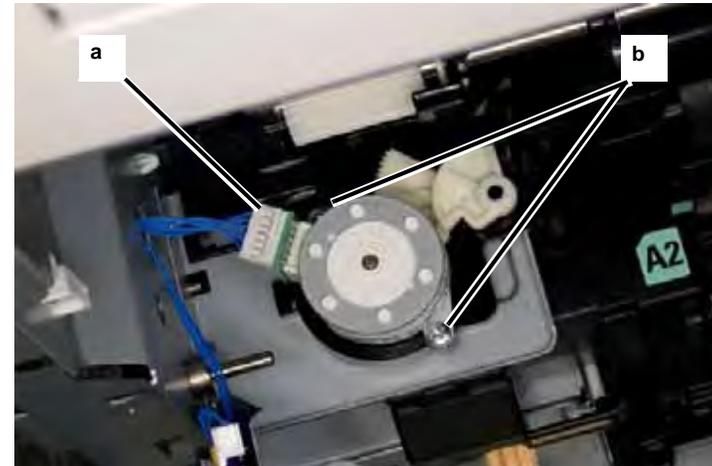
Figure 2 Removing Screws & PJ

4. Perform the following ([Figure 2](#)).
 - a. Disconnect the Offset Motor PJ.
 - b. Remove the Screws (2) and the Offset Motor.

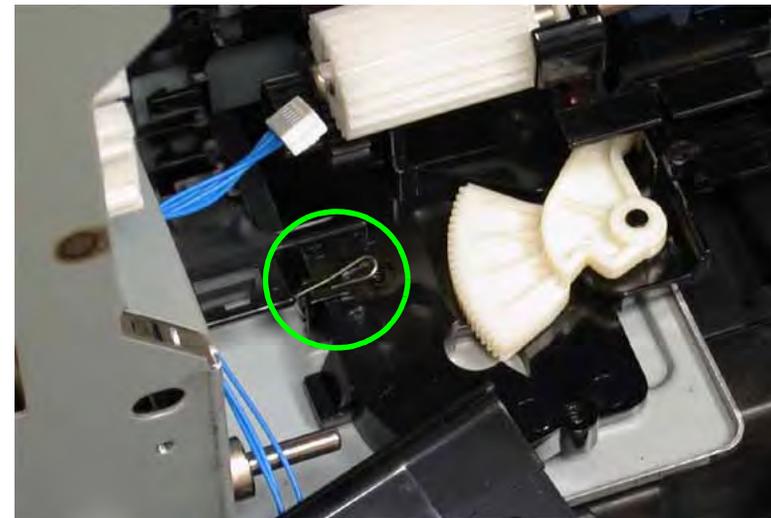
Figure 3 Ground Spring

NOTE: Make sure the Ground Spring for the Offset Motor is captured by the mounting screw when replacing the motor ([Figure 3](#)).

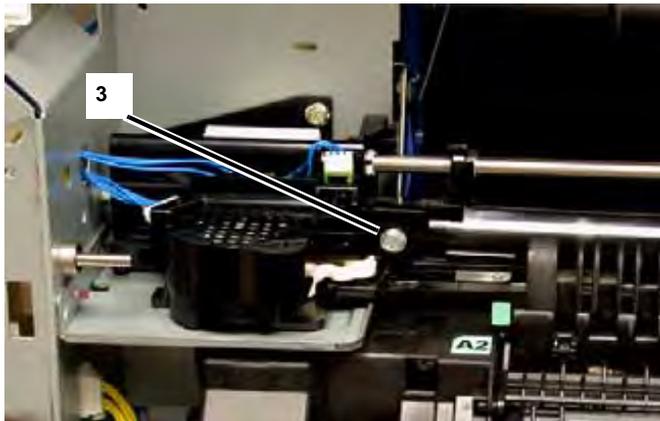
Figure 1 Removing Screw

1. Switch off the power and disconnect the power cord.
2. Remove the Exit 2 Assembly [REP 10.5](#).
3. Remove the Motor Cover (1 Screw) ([Figure 1](#)).

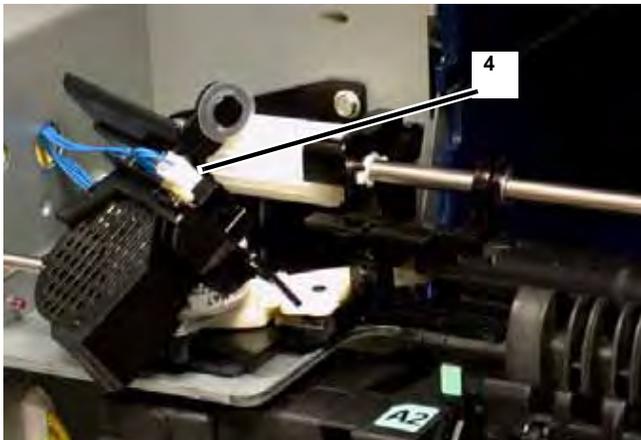
Figure 2 PJ

4. Disconnect the PJ from the sensor, and release the sensor from the cover ([Figure 2](#)).

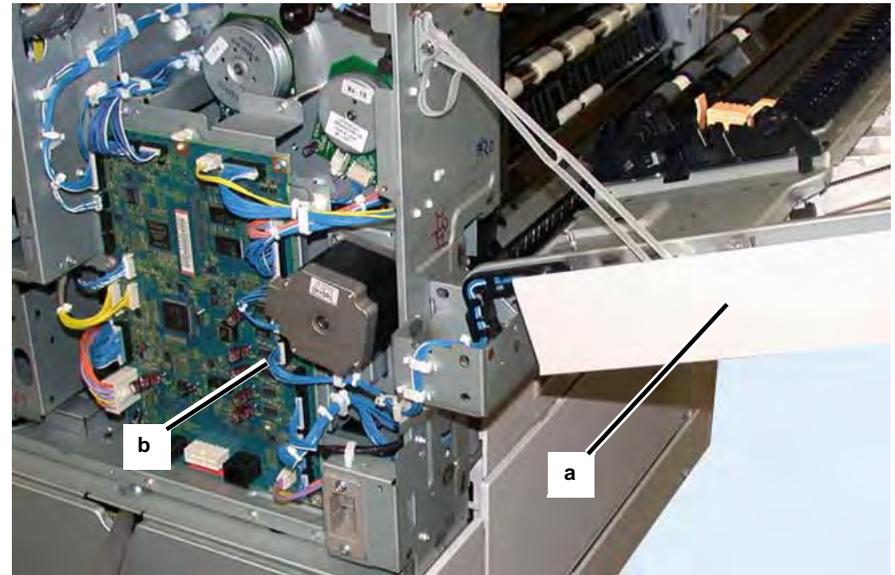
Figure 1 Removal

1. Switch off the power and disconnect the power cord.
2. Remove the MSI Assembly [REP 7.2](#).
3. Perform the following ([Figure 1](#)).
 - a. Open the Left Hand Cover.
 - b. Disconnect PJ409 on the MCU PWB, and release the wire harness from the clamps

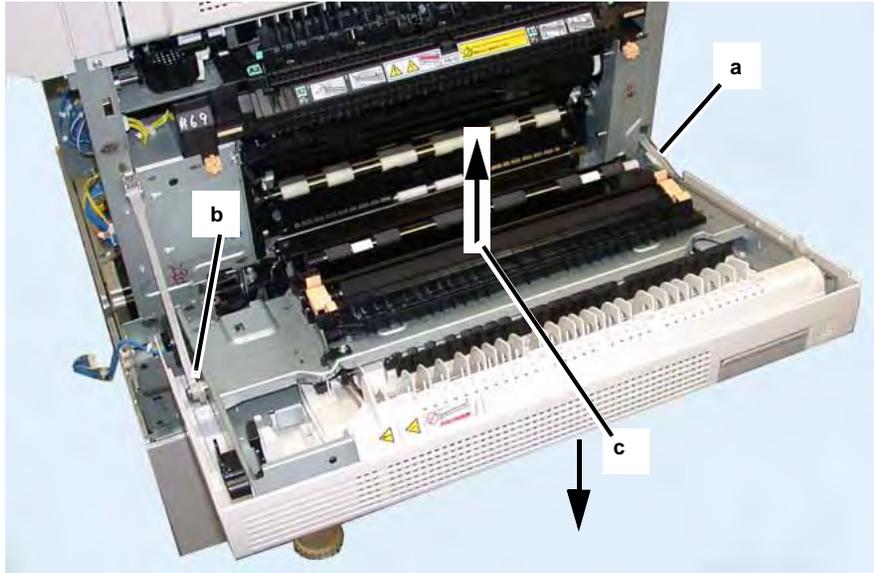
Figure 2 Left Hand Cover Removal

4. Remove the Left Hand Cover Assembly (Figure 2).
 - a. Twist the Front Support and remove it from the slot.
 - b. Remove the K-Clip, and remove the Rear Support from the pin.
 - c. Move the cover down to a horizontal position, then lift it off the pivots.

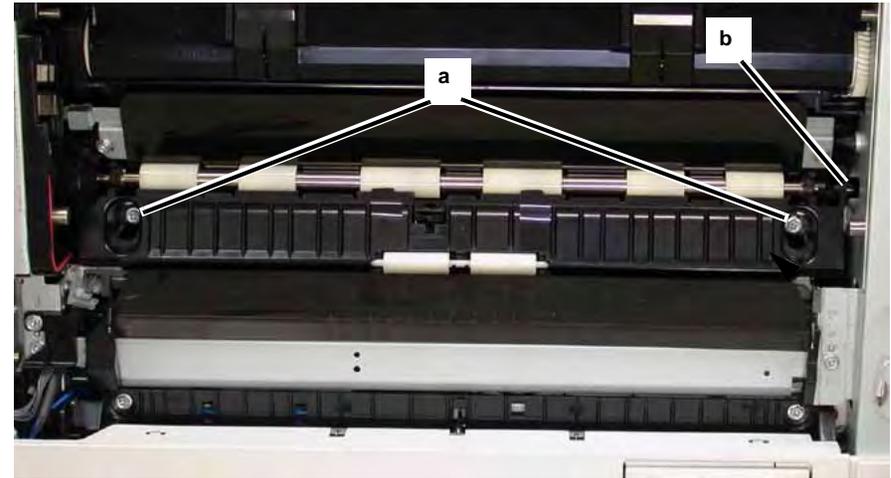
Figure 3 Removing Screws

5. Perform the following (Figure 3).
 - a. Remove the transport Screws (2).
 - b. Move the Front of the transport out of the slot and move the transport out.

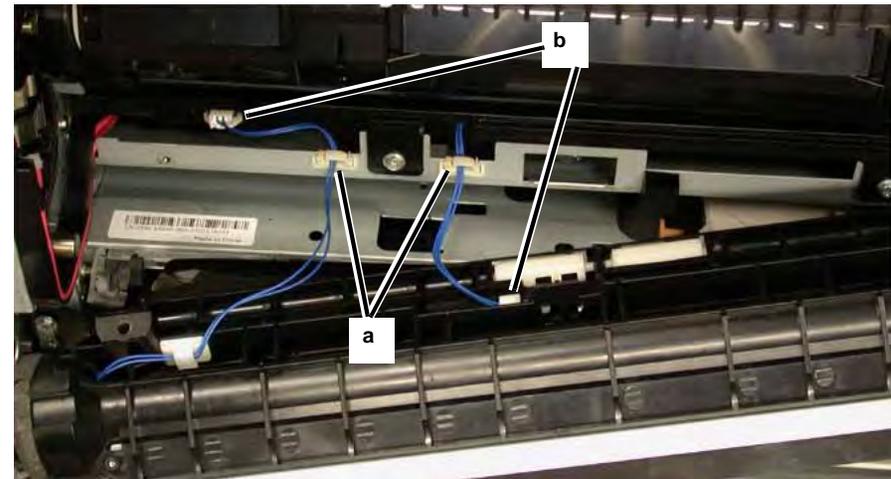
Figure 4 PJ's

6. Remove the Registration Transport (Figure 4).
 - a. Release the wires from the clamps.
 - b. Disconnect the Registration Transport PJ's (2), and remove the transport.

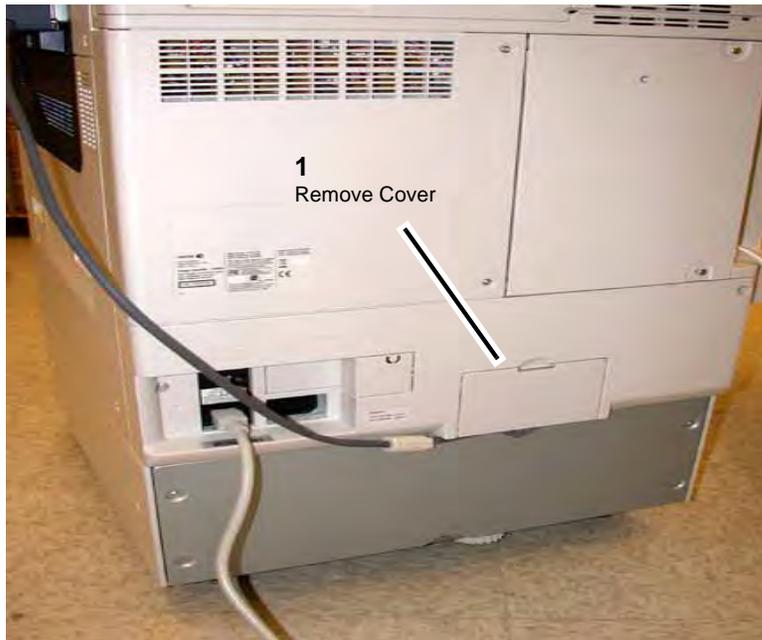
Figure 1 Remove Cover

1. Switch off the power and disconnect the power cord.
2. Disconnect the Integrated Office Finisher Wire Harness:
 - (1) Remove the Cover. (Figure 1)

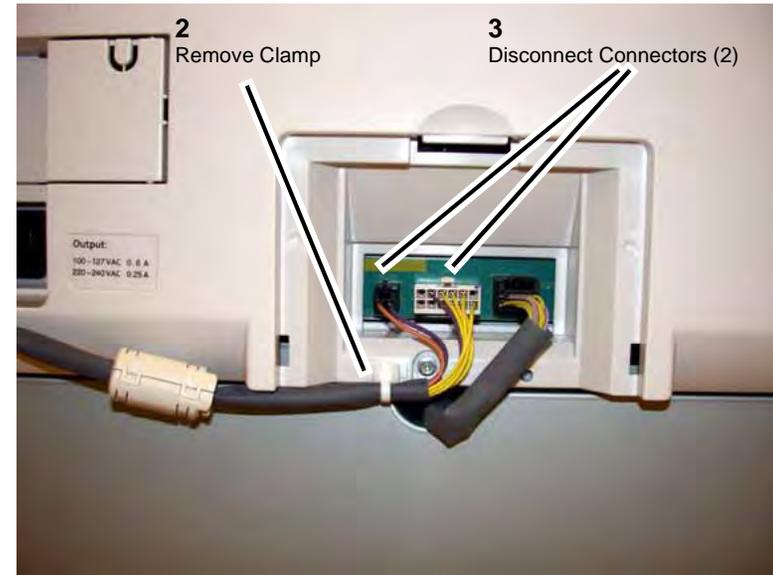
Figure 2 Disconnect Connectors

- (2) Remove Clamp. (Figure 2)
- (3) Disconnect Connectors (2). (Figure 2)

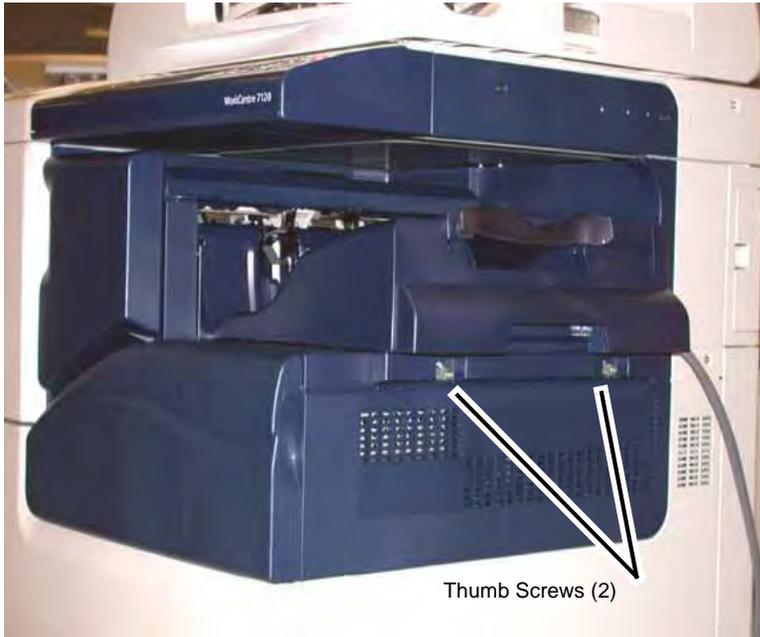
Figure 3 Loosen the Thumb Screws

3. Loosen the Thumb Screws (2) (Figure 3):

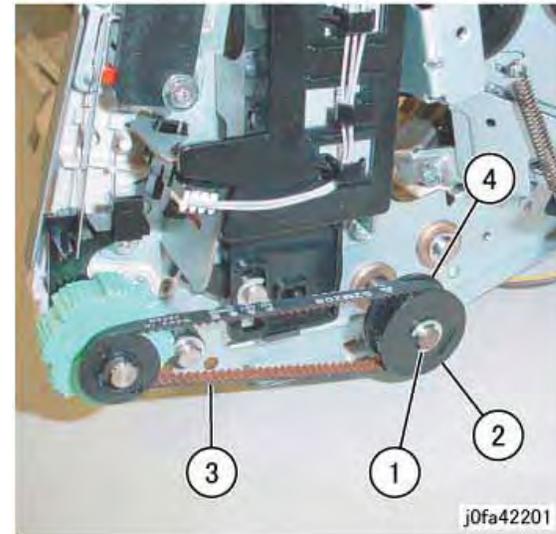
Figure 1 Removing the Pulley

1. Switch off the power and disconnect the power cord
2. Remove the Integrated Office Finisher from the machine ([REP 12.1](#)).
3. Remove the Compiler Assembly ([REP 12.20](#))
4. Remove the front Pulley ([Figure 1](#)):
 - (1) Remove E-Clip.
 - (2) Remove Flange.
 - (3) Remove Belt from Pulley.
 - (4) Remove Pulley.

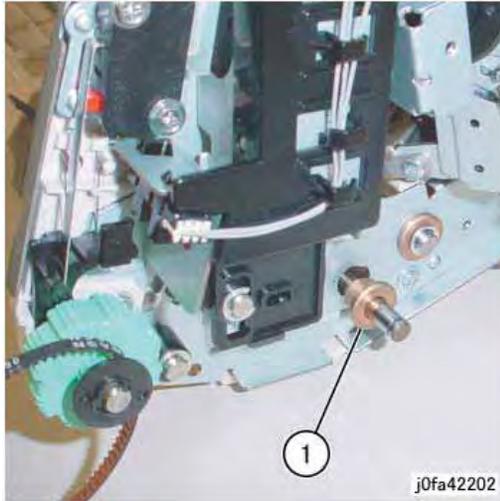
Figure 2 Removing the Front Bearing

5. Remove the Front Bearing ([Figure 2](#)):
 - (1) Remove Bearing.

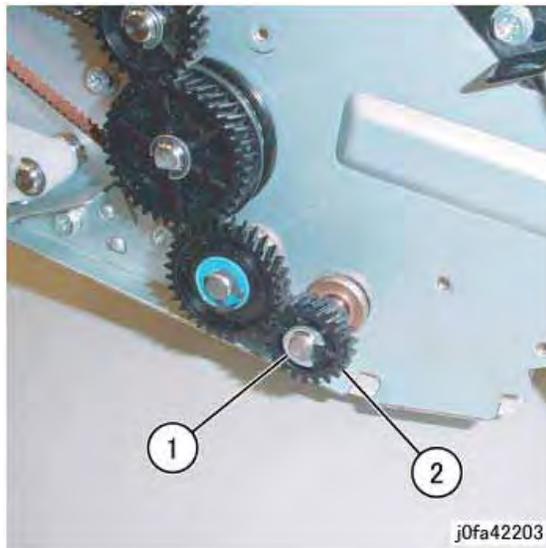
Figure 3 Removing the Gear

6. Remove the Rear Gear (Figure 3)
 - (1)Remove E-Clip.
 - (2)Remove Gear.

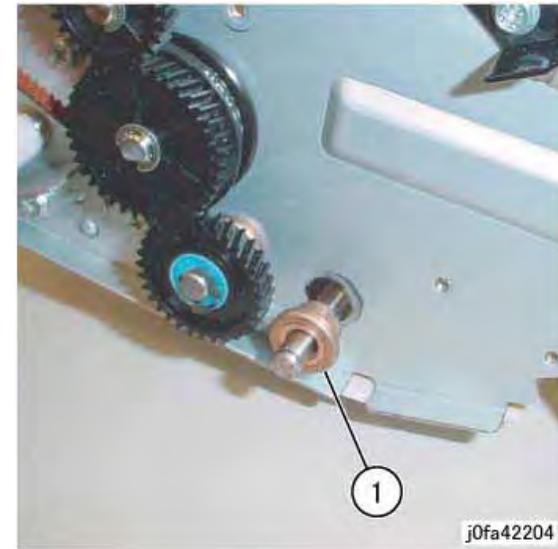
Figure 4 Removing the Bearing

7. Remove the Rear Bearing (Figure 4):

- (1)Remove Bearing.

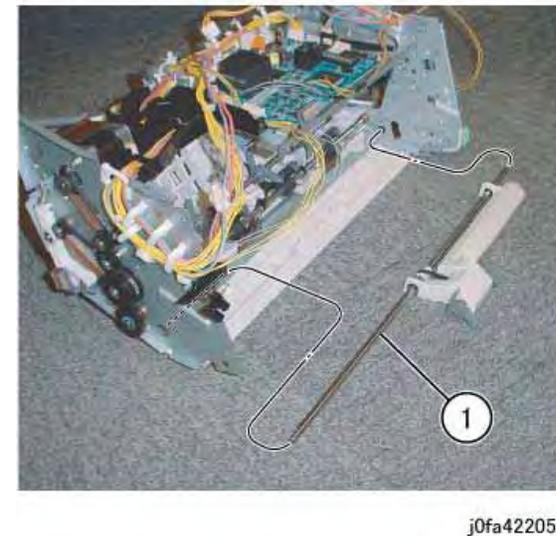
Figure 5 Removing the Paddle Link Assembly

8. Remove the Paddle Link Assembly (Figure 5):
 - (1)Remove Paddle Link Assembly.

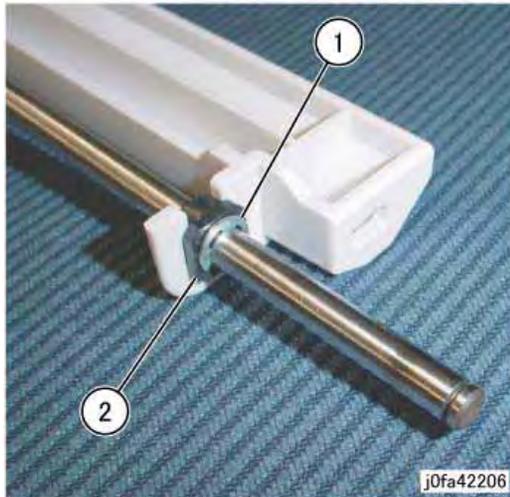
Figure 6 Removing Bearing

9. Remove the Bearing (Figure 6):

- (1) Remove E-Clip.
- (2) Remove Bearing.

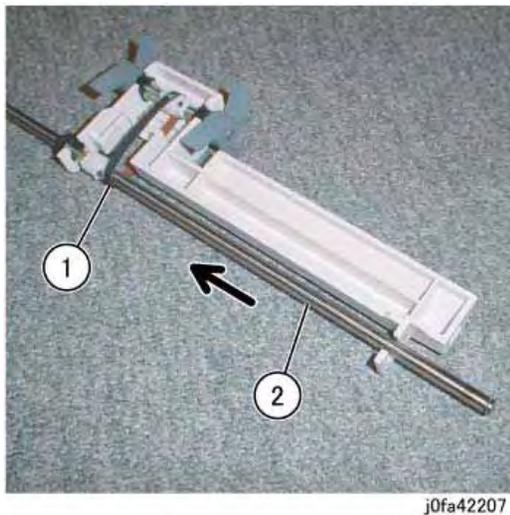
Figure 7 Removing Shaft Assembly

10. Remove the Shaft Assembly (Figure 7):

- (1) Remove Paddle Belt from Pulley.
- (2) Remove Shaft Assembly in the direction of the arrow.

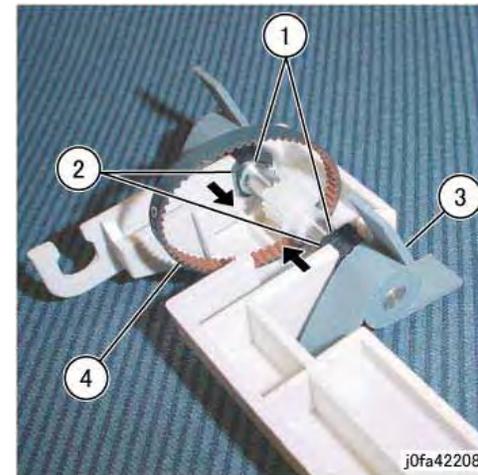
Figure 8 Removing the Paddle Belt

11. Remove the Paddle Belt (Figure 8):

- (1) Remove E-Clips (2).
- (2) Move Bearings (2) in the direction of the arrow.
- (3) Remove Sub Paddle Shaft Assembly.
- (4) Remove Paddle Belt.

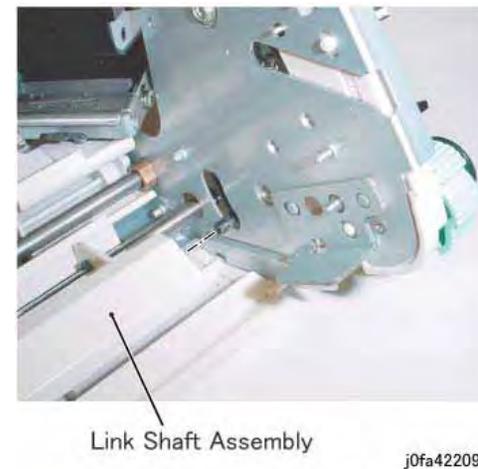
Figure 9 Installing the Paddle Link Assembly

1. Reverse the removal procedure for replacement.
2. Install the Paddle Link Assembly as shown in Figure 9.
