WorkCentre 5335 Family Service Documentation

705P01303

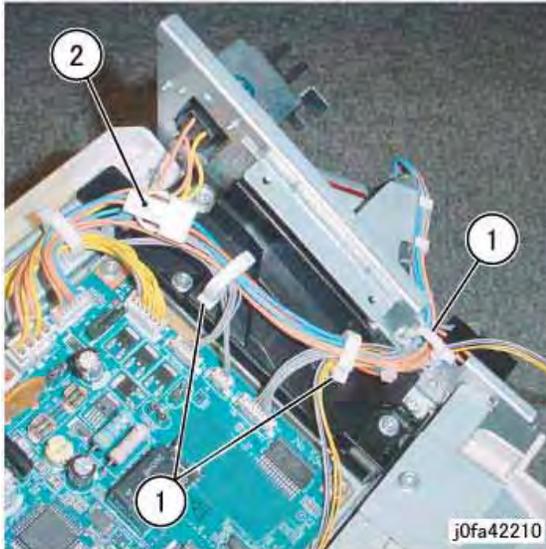
Figure 1 Disconnecting the Connector

1. Switch off the power and disconnect the power cord.
2. Remove the Integrated Office Finisher from the machine (REP 12.1).
3. Remove the Inner Front Cover (PL 22.1)
4. Turn over the Integrated Office Finisher.
5. Remove the Bottom Cover (PL 22.2)
6. Disconnect the Connector (Figure 1):
 - (1)Release Clamps (3) and remove the wire.
 - (2)Disconnect Connector.

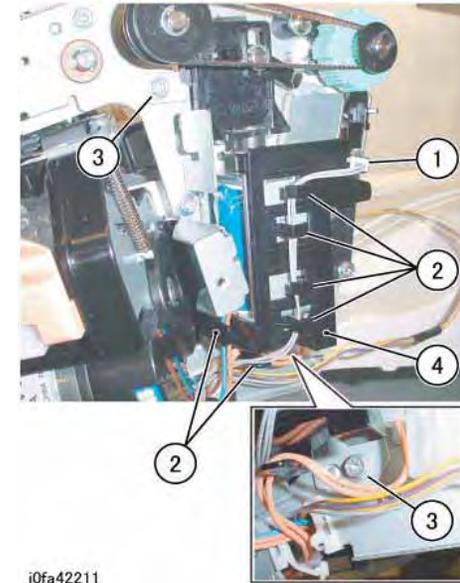
Figure 2 Removing the Sub Paddle Solenoid Assembly

7. Turn over the Integrated Office Finisher.
8. Remove the Sub Paddle Solenoid Assembly (Figure 2):
 - (1)Disconnect Connector.
 - (2)Release Wire from Hook.
 - (3)Remove Screws (2).
 - (4)Remove Sub Paddle Solenoid Assembly.

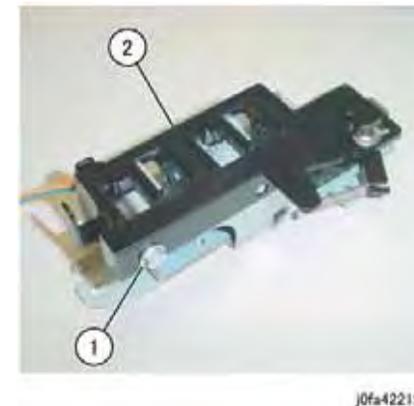
Figure 3 Removing the Support

9. Remove the Support (Figure 3):
 - (1)Remove Screw.
 - (2)Remove Support.

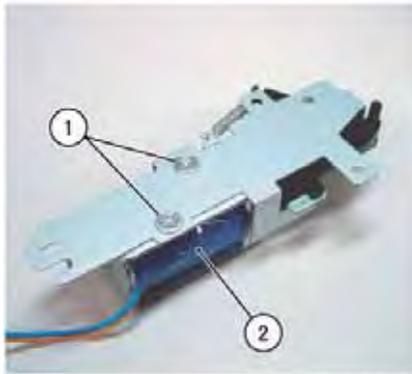
Figure 4 Removing the Sub Paddle Solenoid

10. Remove the Sub Paddle Solenoid (Figure 4):
 - (1)Remove Screws (2).
 - (2)Remove the Sub Paddle Solenoid.

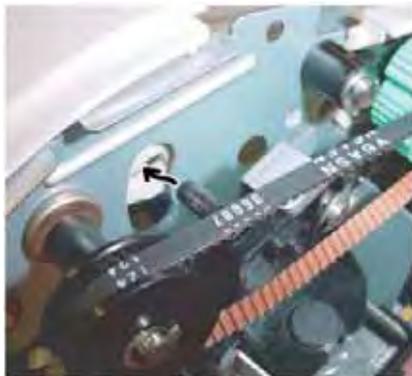
Figure 5 Installing the Sub Paddle Assembly

1. Reverse the removal procedure for replacement.
2. Install the Sub Paddle Assembly as shown in Figure 5.

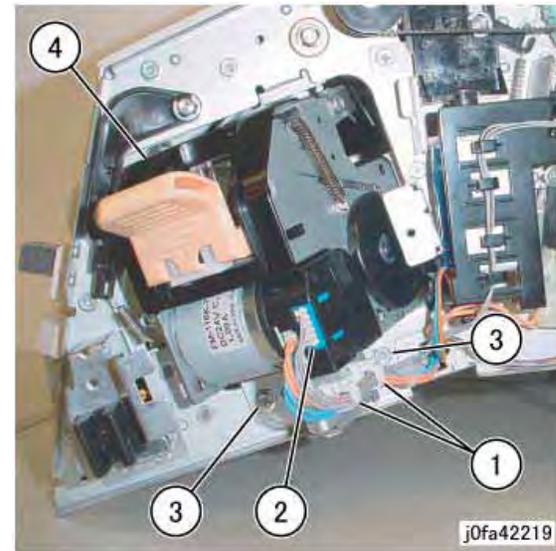
Figure 1 Removing the Staple Assembly

1. Switch off the power and disconnect the power cord.
2. Remove the Integrated Office Finisher from the machine ([REP 12.1](#)).
3. Remove the Inner Front Cover ([PL 22.1](#))
4. Remove the Staple Assembly ([Figure 1](#)):
 - (1)Remove Clamps (2).
 - (2)Disconnect Connectors (2).
 - (3)Remove Screws (2).
 - (4)Remove Staple Assembly.

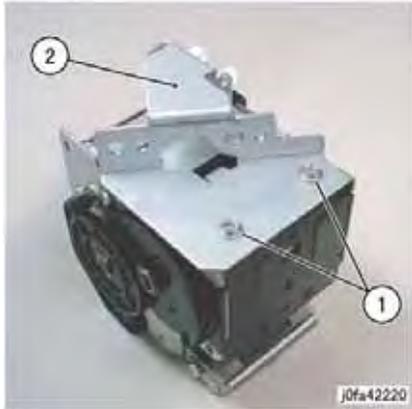
Figure 2 Removing the Bracket

5. Remove the Bracket from the Staple Assembly ([Figure 2](#)):
 - (1)Remove Screws (2).
 - (2)Remove Bracket.

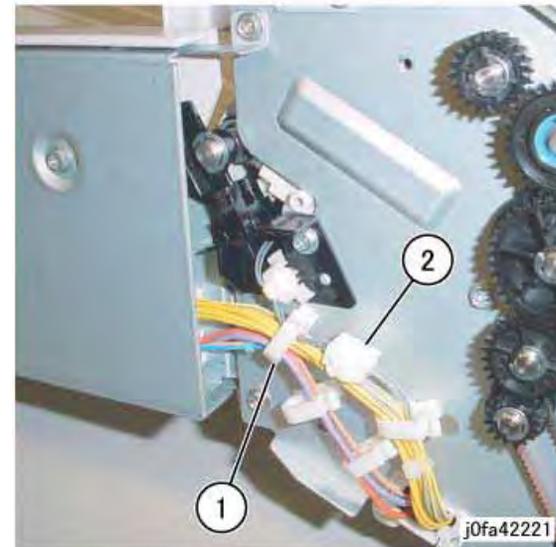
Figure 1 Disconnecting Connector

1. Switch off the power and disconnect the power cord.
2. Remove the Integrated Office Finisher from the machine ([REP 12.1](#)).
3. Remove the Rear Cover ([PL 22.1](#))
4. Disconnect the Connector ([Figure 1](#)):
 - (1)Release Clamp and remove the wire.
 - (2)Disconnect Connector.

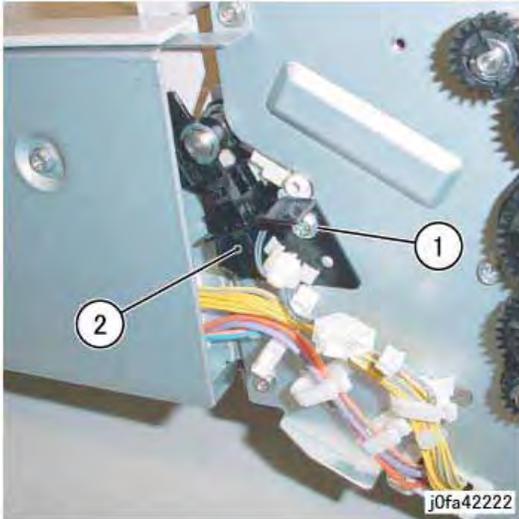
Figure 2 Removing the Set Clamp Home Sensor Assembly

5. Remove the Set Clamp Home Sensor Assembly ([Figure 2](#)):
 - (1)Remove Screw.
 - (2)Remove Set Clamp Home Sensor Assembly.

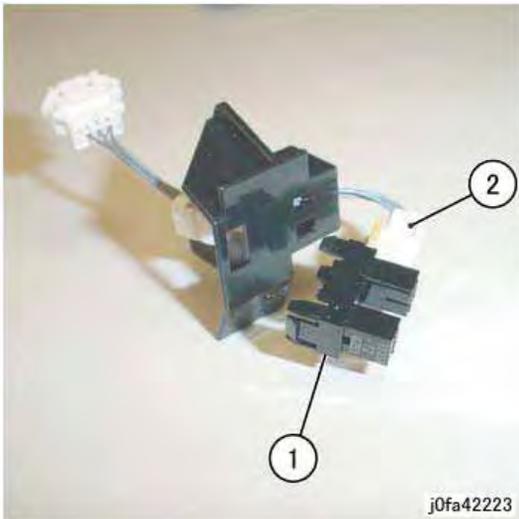
Figure 3 Removing the Set Clamp Home Sensor

6. Remove the Set Clamp Home Sensor (Figure 3):
 - (1) Remove Set Clamp Home Sensor from Bracket.
 - (2) Disconnect Connector.

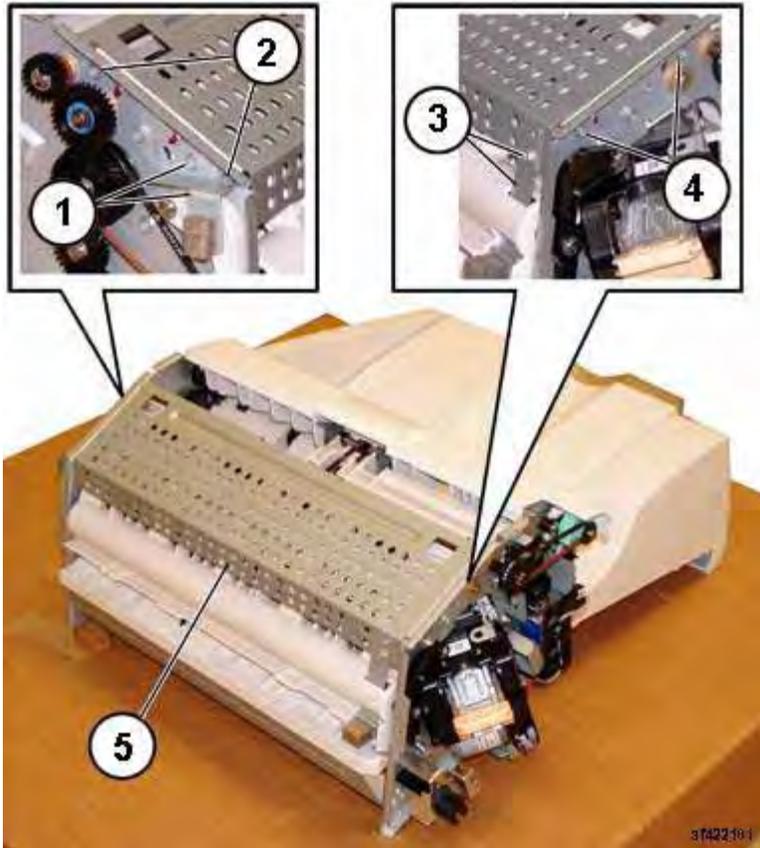
Figure 1 Removing the Upper Frame Section

1. Switch off the power and disconnect the power cord.
2. Remove the Integrated Office Finisher from the machine ([REP 12.1](#)).
3. Remove the Inner Front Cover ([PL 22.1](#))
4. Remove the Rear Cover ([PL 22.1](#))
5. Remove the Left Cover ([PL 22.2](#))
6. Remove the Upper Frame Section (Figure 1):
 - (1) Remove Screw and Bracket.
 - (2) Remove Screws (2).
 - (3) Remove Screw and Bracket.
 - (4) Remove Screws (2).
 - (5) Remove the Upper Frame Section

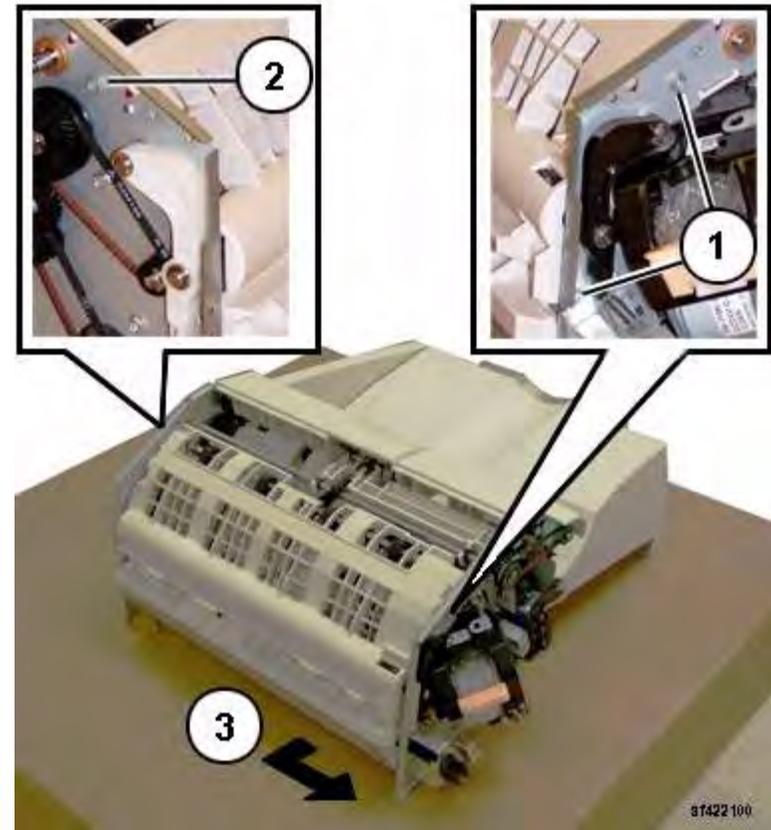
Figure 2 Removing the Upper Chute Assembly

NOTE: The screws do not thread into the Upper Chute. They are used like pins to secure the Upper Chute in place.

7. Remove the Upper Chute Assembly (Figure 2):
 - (1) Remove Screws (2).
 - (2) Remove Screw.
 - (3) Carefully Remove the Upper Chute Assembly.

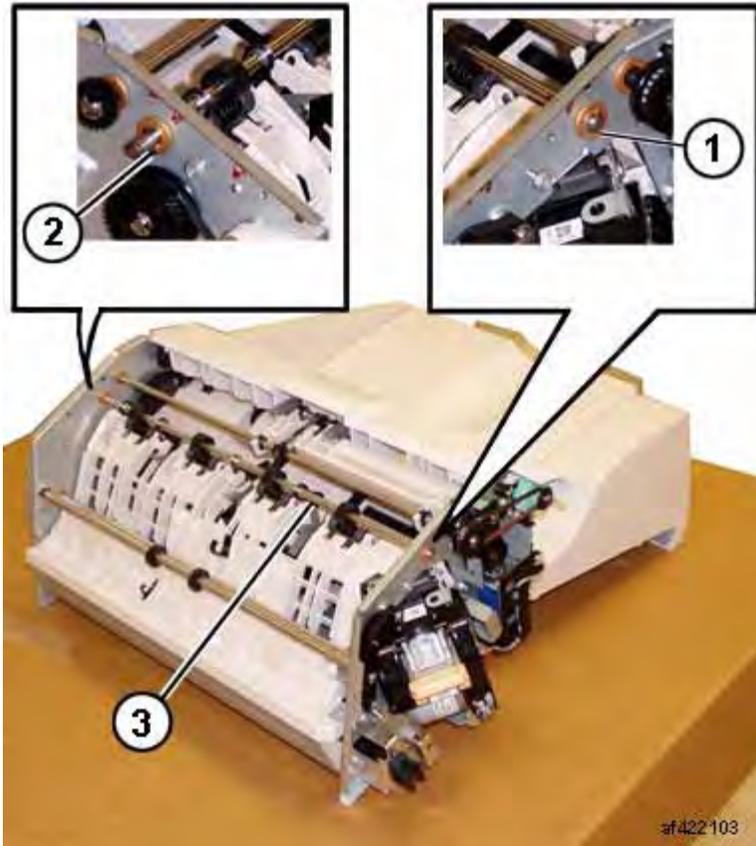
Figure 3 Removing the Exit Roll Assembly

8. Remove the Exit Roll Assembly (Figure 3):
 - (1) Remove E-ring and Bearing.
 - (2) Remove E-ring and Bearing.
 - (3) Remove the Exit Roll Assembly.

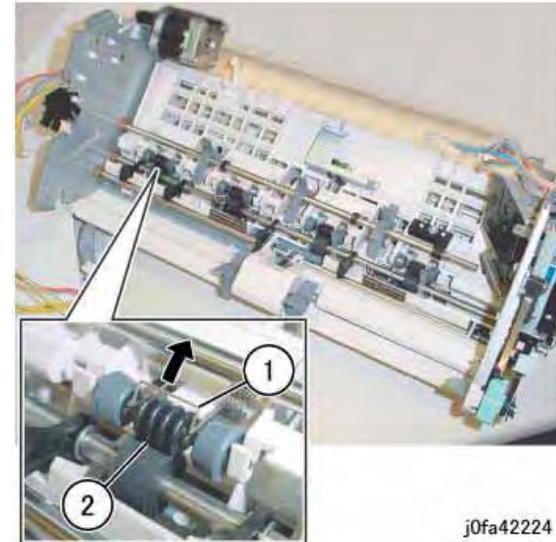
Figure 1 Removing the Pinch Rolls

1. Switch off the power and disconnect the power cord.
2. Remove the Integrated Office Finisher from the machine (REP 12.1).
3. Remove the Compiler Assembly (REP 12.20)
4. Remove the Pinch Roll (Figure 1):
 - (1) Raise Springs (4) in the direction of the arrow.
 - (2) Remove Pinch Rolls (4).

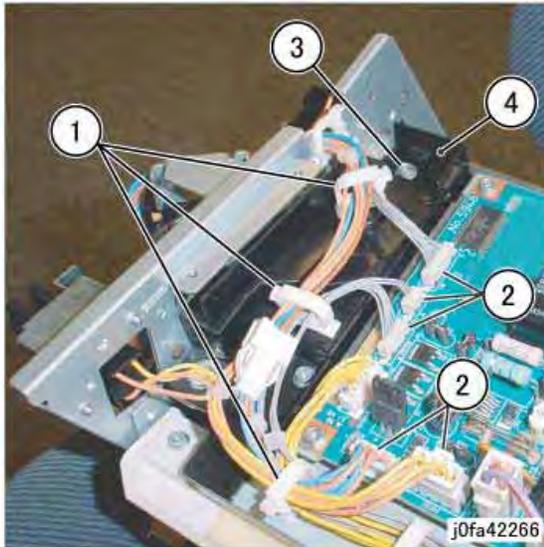
Figure 1 Removing the Connector Bracket

1. Switch off the power and disconnect the power cord.
2. Remove the Integrated Office Finisher from the machine (REP 12.1).
3. Turn over the Integrated Office Finisher.
4. Remove the Bottom Cover (PL 22.2)
5. Remove the Connector Bracket (Figure 1):
 - (1)Release Clamps (3) and remove the wire.
 - (2)Disconnect Connectors (5).
 - (3)Remove Screws (2).
 - (4)Remove Connector Bracket.

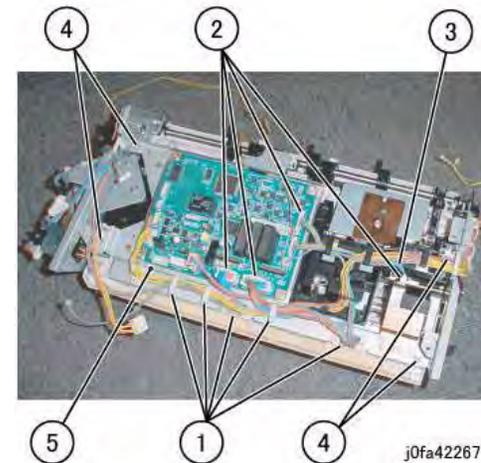
Figure 2 Removing the Bottom Plate

6. Remove the Bottom Plate (Figure 2):
 - (1)Release Clamps (5) and remove the wire.
 - (2)Disconnect Connectors (8).
 - (3)Remove Wire from Hook.
 - (4)Remove Screws (4).
 - (5)Remove Bottom Plate.

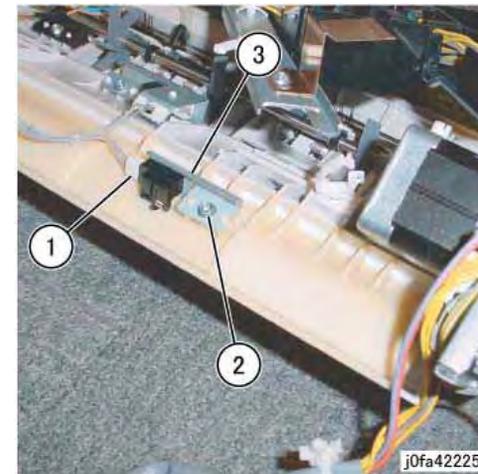
Figure 3 Removing the Finisher Entrance Sensor Assembly

7. Remove the Finisher Entrance Sensor Assembly (Figure 3):
 - (1)Disconnect Connector.
 - (2)Remove Self-tapping Screw.
 - (3)Remove Finisher Entrance Sensor Assembly.

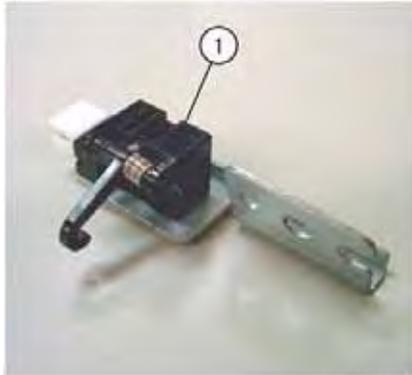
Figure 4 Removing the Finisher Entrance Sensor

8. Remove the Finisher Entrance Sensor (Figure 4):
 - (1)Remove Finisher Entrance Sensor from Bracket.

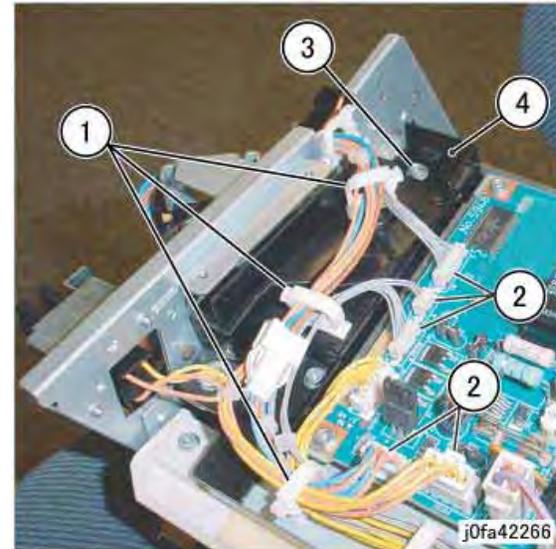
Figure 1 Removing the Connector Bracket

1. Switch off the power and disconnect the power cord.
2. Remove the Integrated Office Finisher from the machine ([REP 12.1](#)).
3. Turn over the Integrated Office Finisher.
4. Remove the Bottom Cover ([PL 22.2](#))
5. Remove the Connector Bracket ([Figure 1](#)):
 - (1)Release Clamps (3) and remove the wire.
 - (2)Disconnect Connectors (5).
 - (3)Remove Screws (2).
 - (4)Remove Connector Bracket.

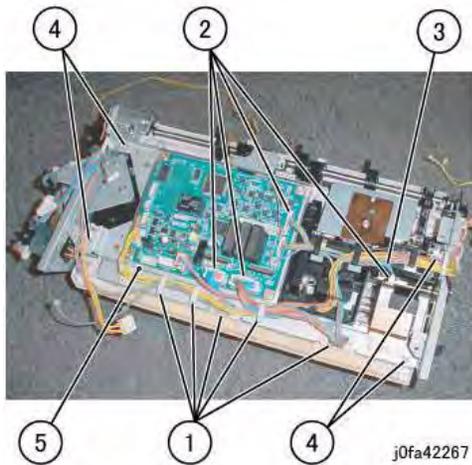
Figure 2 Removing the Bottom Plate

6. Remove the Bottom Plate ([Figure 2](#)):
 - (1)Release Clamps (5) and remove the wire.
 - (2)Disconnect Connectors (8).
 - (3)Release Wire from Hook.
 - (4)Remove Screws (4).
 - (5)Remove Bottom Plate.

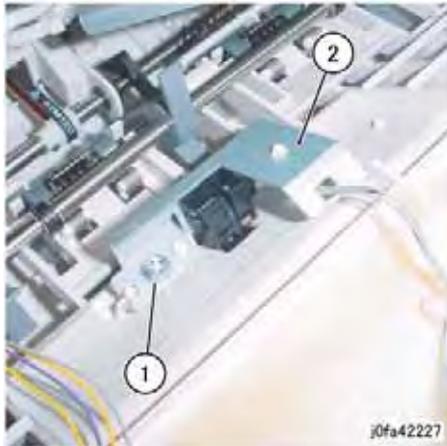
Figure 3 Removing the Compiler Exit Sensor Assembly

7. Remove the Compiler Exit Sensor Assembly (Figure 3):
 - (1) Remove Screw.
 - (2) Remove Compiler Exit Sensor Assembly.

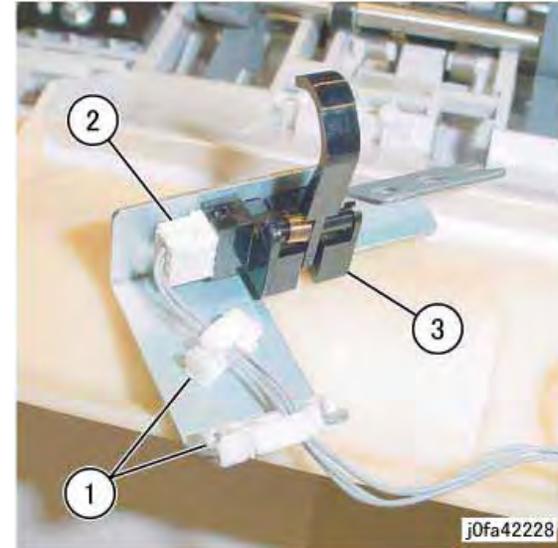
Figure 4 Removing the Compiler Exit Sensor

8. Remove the Compiler Exit Sensor (Figure 4):
 - (1) Release Clamps (2) and remove the wire.
 - (2) Disconnect Connector.
 - (3) Remove Compiler Exit Sensor.

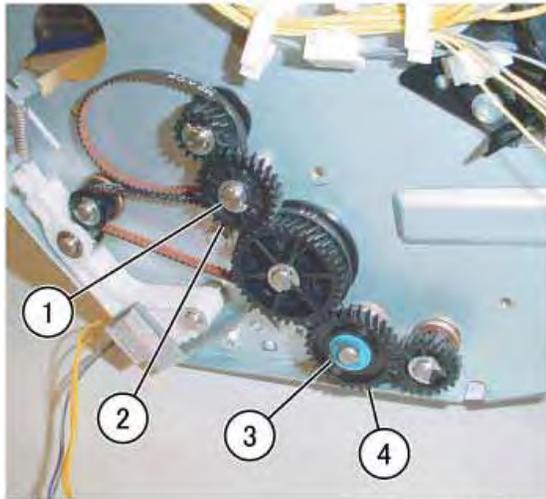
Figure 1 Removing the Gear

1. Switch off the power and disconnect the power cord.
2. Remove the Integrated Office Finisher from the machine ([REP 12.1](#)).
3. Remove the Compiler Assembly ([REP 12.20](#))
4. Remove the Gear ([Figure 1](#)):
 - (1)Remove E-Clip.
 - (2)Remove Gear.
 - (3)Remove KL-Clip.
 - (4)Remove Gear.

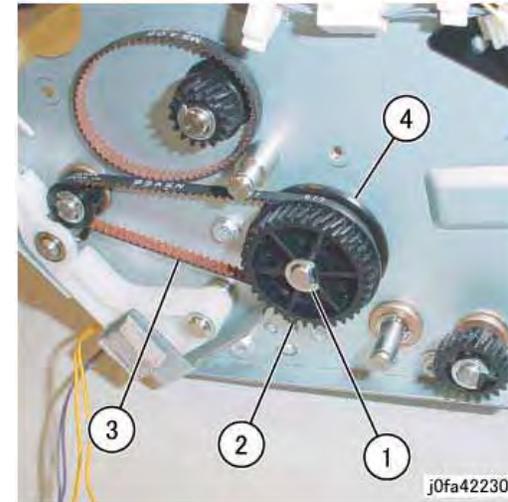
Figure 2 Removing the Gear Pulley

5. Remove the Gear Pulley ([Figure 2](#)):
 - (1)Remove E-Clip.
 - (2)Remove Gear.
 - (3)Remove Flange.

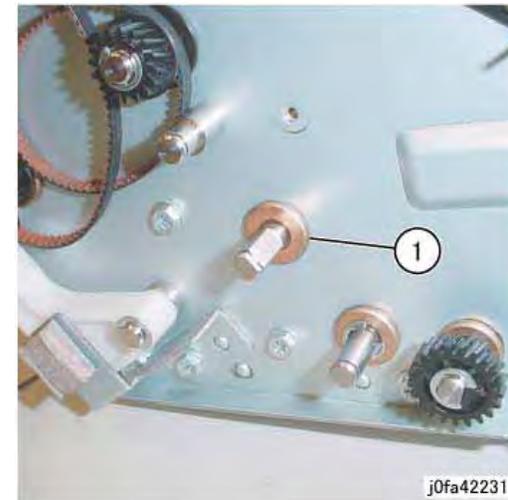
Figure 3 Removing the Bearing

6. Remove the Bearing ([Figure 3](#)):
 - (1)Remove Bearing.

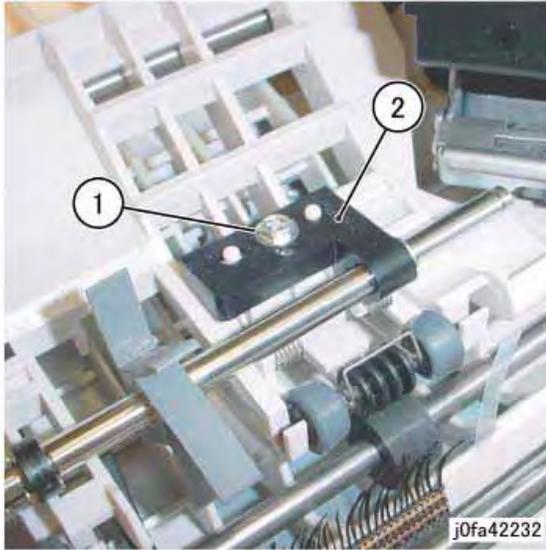
Figure 4 Removing the Support Bearing

7. Remove the Support Bearing from the Entrance Lower Chute Assembly ([Figure 4](#)):
 - (1)Remove Self-tapping Screw.
 - (2)Remove Support Bearing.

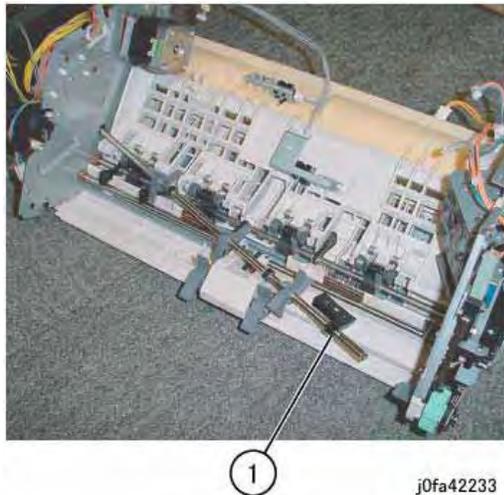
Figure 5 Removing the Main Paddle Shaft Assembly

8. Remove the Main Paddle Shaft Assembly (Figure 5):
(1)Remove Main Paddle Shaft Assembly.

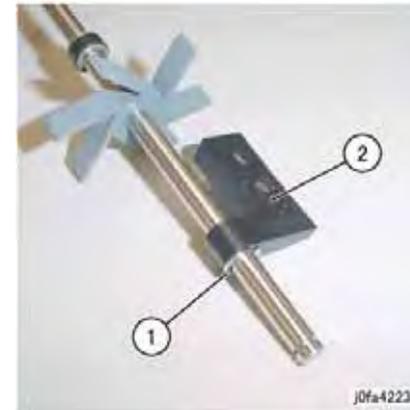
Figure 6 Removing the Support Bearing

9. Remove the Support Bearing from the Main Paddle Shaft Assembly (Figure 6):
(1)Remove E-Clip.

(2)Remove Support Bearing.

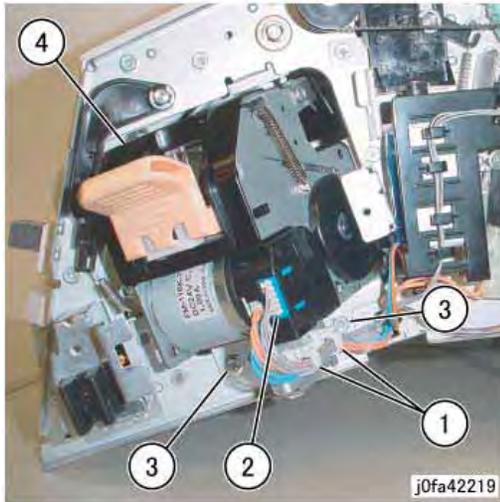
Figure 1 Removing the Stapler Assembly

1. Switch off the power and disconnect the power cord.
2. Remove the Integrated Office Finisher from the machine ([REP 12.1](#)).
3. Remove the Compiler Assembly ([REP 12.20](#))
4. Turn over the Integrated Office Finisher (Transport).
5. Remove the Stapler Assembly ([Figure 1](#)):
(1)Release Clamps (2) and remove the wire.
(2)Disconnect Connectors (2).
(3)Remove Screws (2).
(4)Remove Stapler Assembly.

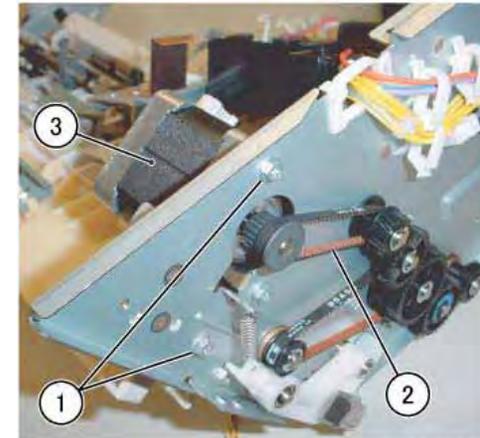
Figure 2 Removing the Transport Motor

6. Turn over the Integrated Office Finisher.
7. Remove the Transport Motor ([Figure 2](#)):
(1)Remove Screws (2).
(2)Remove Belt from Pulley.
(3)Remove Transport Motor.

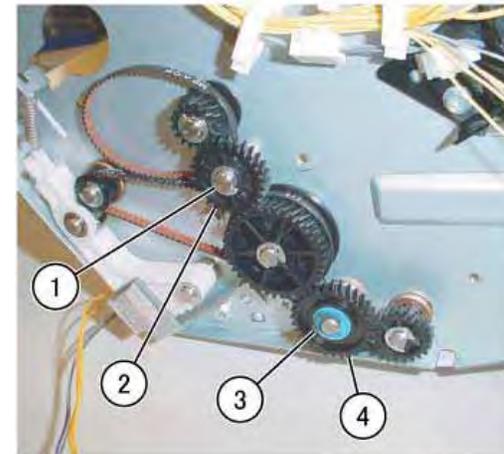
Figure 3 Removing the Gear

8. Remove the Gear ([Figure 3](#)):
(1)Remove E-Clip.
(2)Remove Gear.
(3)Remove KL-Clip.
(4)Remove Gear.

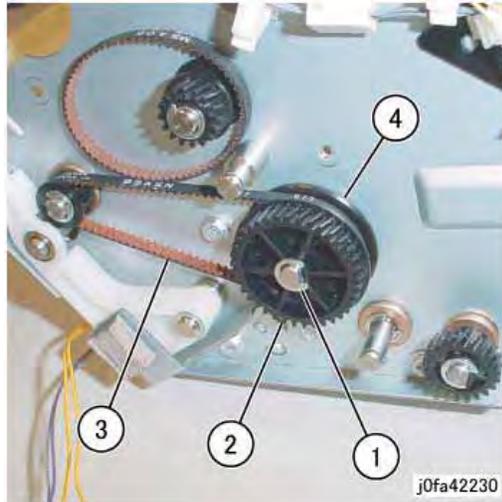
Figure 4 Removing the Gear Pulley

9. Remove the Gear Pulley ([Figure 4](#)):
(1)Remove E-Clip.

- (2)Remove Gear.
- (3)Remove Pulley from Belt.
- (4)Remove Flange.

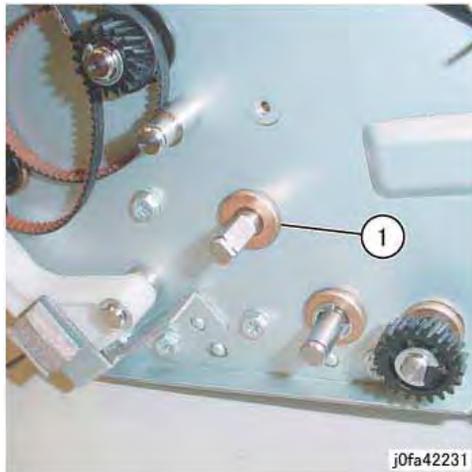
Figure 5 Removing the Bearing

- 10. Remove the Bearing (Figure 5):
- (1)Remove the Bearing.

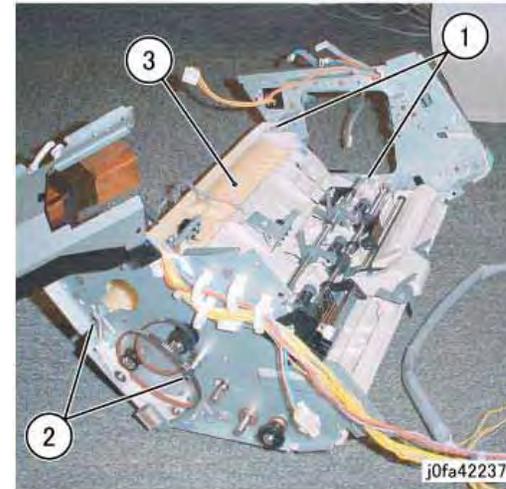
Figure 6 Removing the Entrance Lower Chute Assembly

- 11. Remove the Entrance Lower Chute Assembly (Figure 6):
- (1)Remove Screws (2).

- (2)Loosen Screws (2).
- (3)Remove Entrance Lower Chute Assembly.

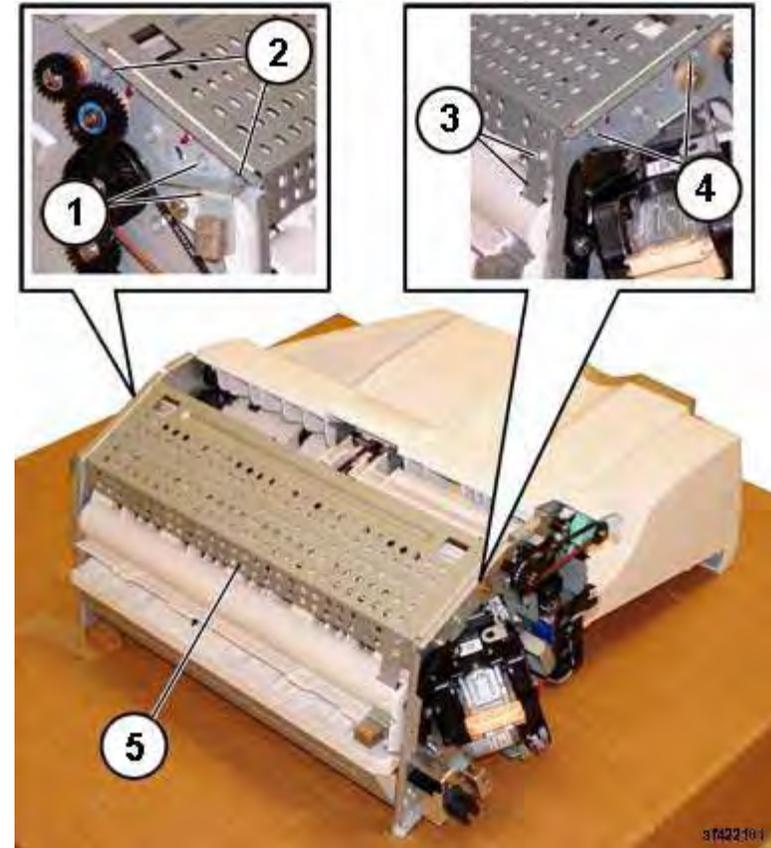
Figure 1 Removing the Upper Frame Section

1. Switch off the power and disconnect the power cord.
2. Remove the Integrated Office Finisher from the machine ([REP 12.1](#)).
3. Remove the Inner Front Cover ([PL 22.1](#))
4. Remove the Rear Cover ([PL 22.1](#))
5. Remove the Left Cover ([PL 22.2](#))
6. Remove the Upper Frame Section ([Figure 1](#)):
 - (1)Remove Screw and Bracket.
 - (2)Remove Screws (2).
 - (3)Remove Screw and Bracket.
 - (4)Remove Screws (2).
 - (5)Remove the Upper Frame Section

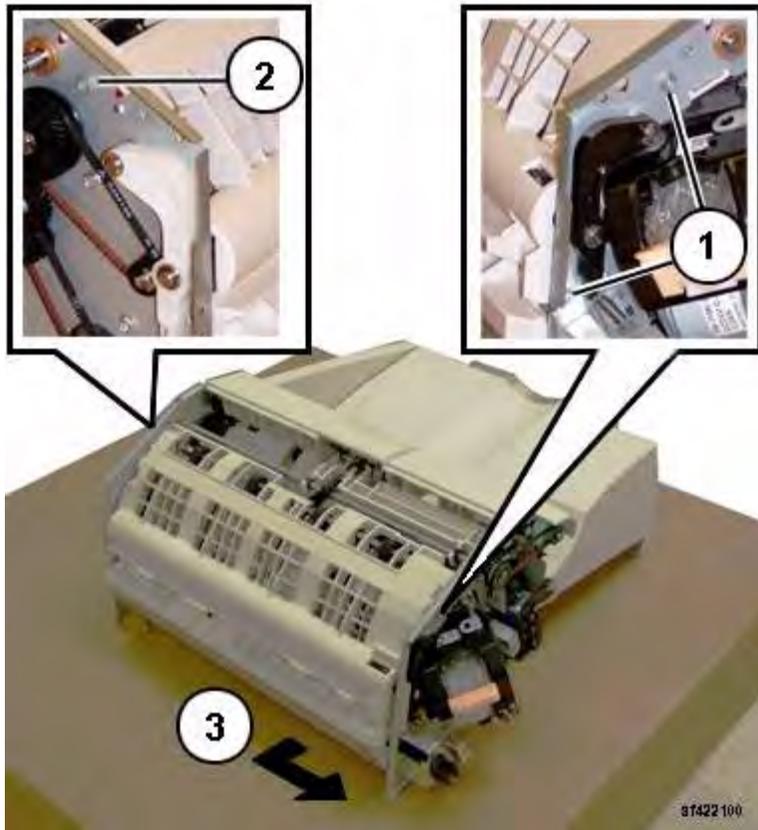
Figure 2 Removing the Upper Chute Assembly

NOTE: The screws do not thread into the Upper Chute. They are used like pins to secure the Upper Chute in place.

7. Remove the Upper Chute Assembly ([Figure 2](#)):
 - (1)Remove Screws (2).
 - (2)Remove Screw.
 - (3)Carefully Remove the Upper Chute Assembly.

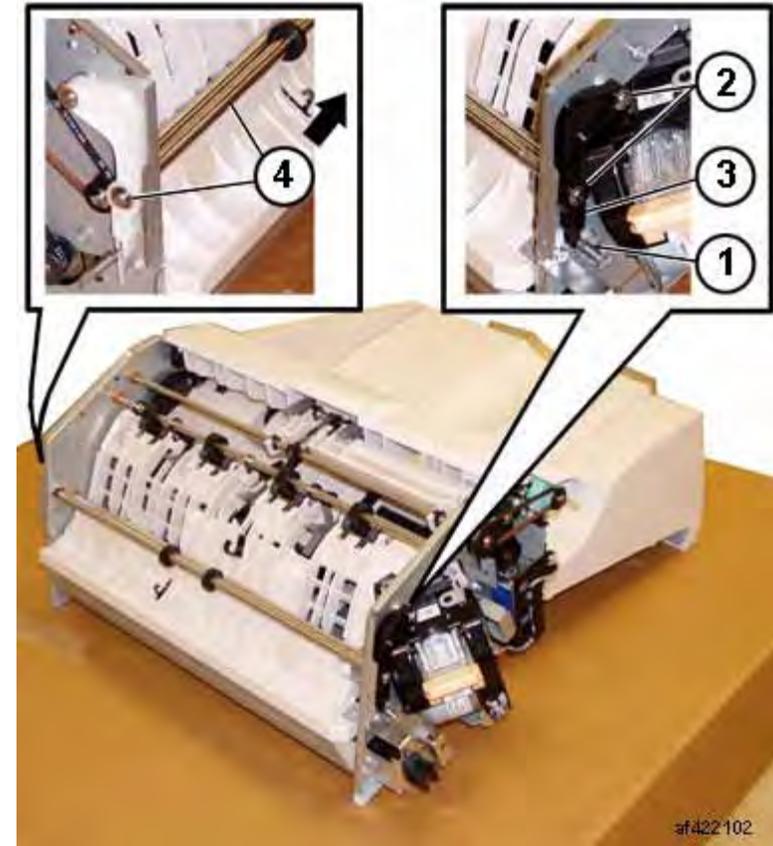
Figure 3 Removing the Gear

8. Remove the Entrance Roll Assembly (Figure 3):

NOTE: Capture the Bearing

- (3) Remove Arm.
- (4) Slide Shaft out of the Bearing in the Arm.

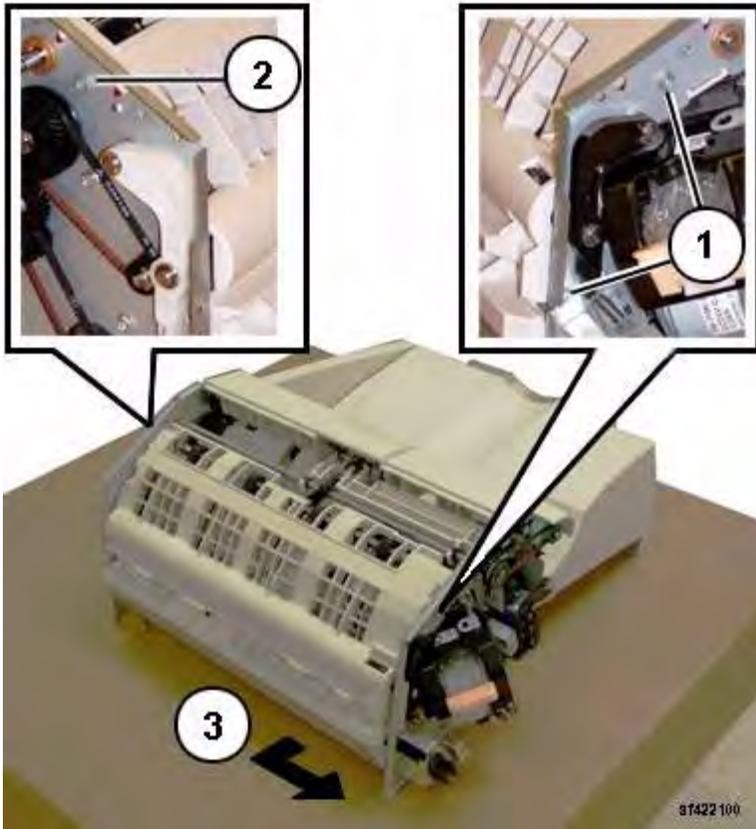
Figure 2 Removing the Upper Chute Assembly

NOTE: The screws do not thread into the Upper Chute. They are used like pins to secure the Upper Chute in place.

7. Remove the Upper Chute Assembly ([Figure 2](#)):
 - (1)Remove Screws (2).
 - (2)Remove Screw.
 - (3)Carefully Remove the Upper Chute Assembly.

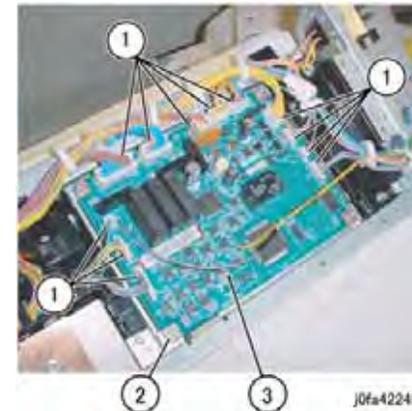
Figure 1 Removing the Finisher PWB

1. Switch off the power and disconnect the power cord.
2. Remove the Integrated Office Finisher from the machine (REP 12.1).
3. Turn over the Finisher.
4. Remove the Bottom Cover (PL 22.2)
5. Remove the Finisher PWB (Figure 1):
 - (1) Disconnect Connectors (12).
 - (2) Remove Screws (4).
 - (3) Remove Finisher PWB.

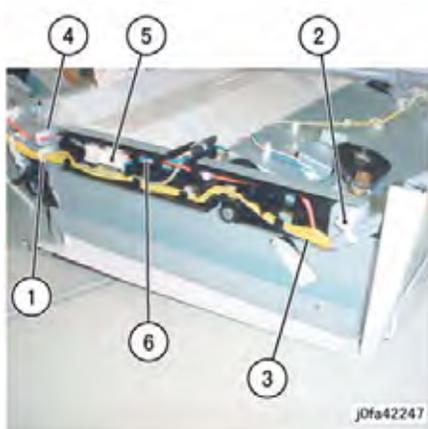
Figure 1 Disconnecting the Connector

1. Switch off the power and disconnect the power cord.
2. Remove the Integrated Office Finisher from the machine ([REP 12.1](#)).
3. Remove the Inner Front Cover ([PL 22.1](#))
4. Remove the Rear Cover ([PL 22.1](#))
5. Turn over the Integrated Office Finisher.
6. Remove the Bottom Cover ([PL 22.2](#))
7. Remove the Tray Cover ([PL 22.2](#))
8. Disconnect Connector ([Figure 1](#)):
 - (1)Release Clamp.
 - (2)Remove Clamp.
 - (3)Release and remove Wire from Hook.
 - (4)Release Clamp.
 - (5)Disconnect Connector.
 - (6)Release and remove Wire from Hook.

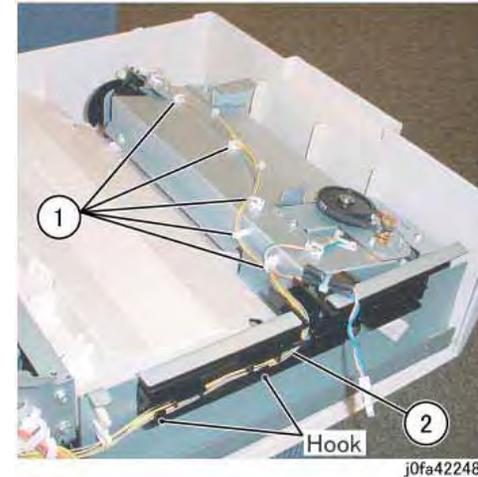
Figure 2 Disconnecting the Wire

9. Release the Clamps and the Hook to remove the wire ([Figure 2](#)):
 - (1)Release Clamps (5).
 - (2)Remove Wire from Hook.

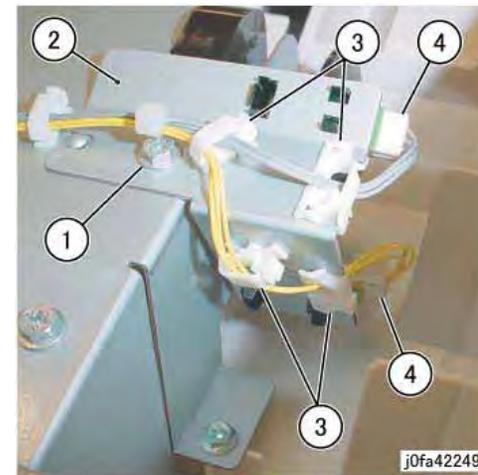
Figure 3 Removing the Stacker Sensor Assembly

10. Remove the Stacker Sensor Assembly ([Figure 3](#)):
 - (1)Remove Screw.
 - (2)Remove Stacker Sensor Assembly.
 - (3)Release Clamps (4).
 - (4)Disconnect Connectors (2).

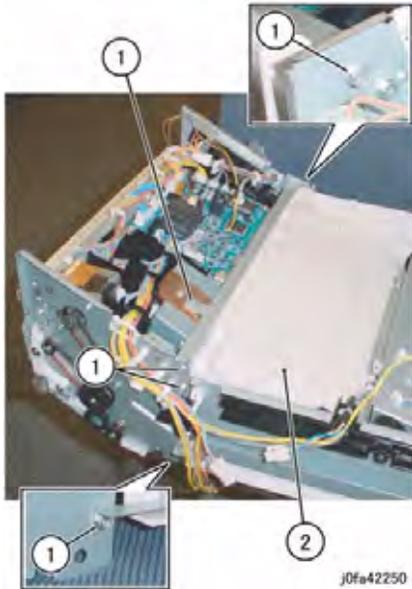
Figure 4 Removing the Stacker Tray Assembly

11. Remove the Stacker Tray Assembly ([Figure 4](#)):
 - (1)Remove Screws (5).
 - (2)Remove Stacker Tray Assembly.

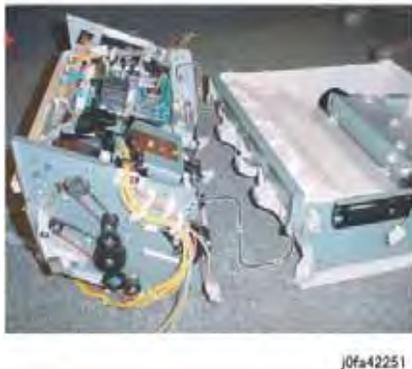
Figure 5 Installing the Stacker Tray Assembly

1. Reverse the removal procedure for replacement.
2. Install the Stacker Tray Assembly and Integrated Office Finisher as shown in [Figure 5](#).

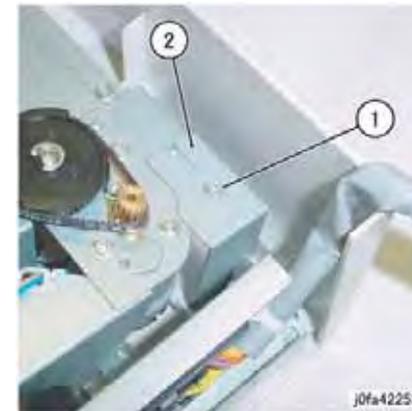
Figure 1 Removing the Rear Bracket

1. Switch off the power and disconnect the power cord.
2. Remove the Integrated Office Finisher from the machine ([REP 12.1](#)).
3. Remove the Rear Cover ([PL 22.1](#))
4. Turn over the Integrated Office Finisher.
5. Remove the Tray Cover ([PL 22.2](#))
6. Remove the rear Bracket ([Figure 1](#)):
 - (1) Remove Screw.
 - (2) Remove Bracket.

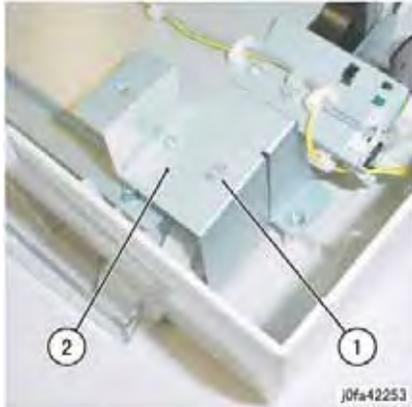
Figure 2 Removing the Front Bracket

7. Remove the front Bracket ([Figure 2](#)):
 - (1) Remove Screw.
 - (2) Remove Bracket.

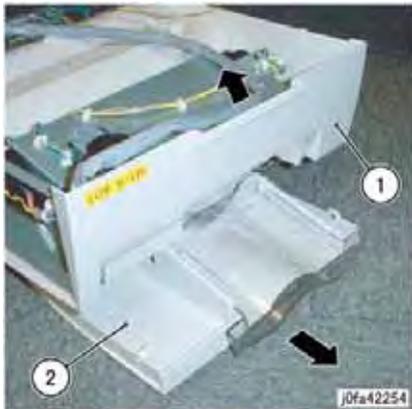
Figure 3 Removing the Top Tray

8. Remove the Top Tray (Figure 3):
 - (1) Raise Integrated Office Finisher slightly in the direction of the arrow.
 - (2) Remove Top Tray.

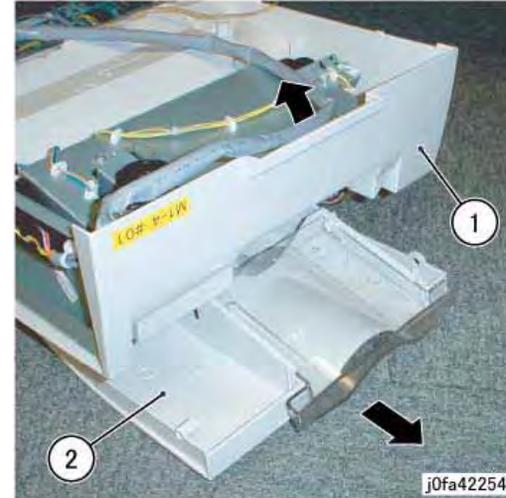
Figure 4 Disconnecting the Connector

9. Disconnect Connector (Figure 4):
 - (1) Release Clamps (5) and remove the wire.
 - (2) Release Wire from Hook.
 - (3) Disconnect Connector.

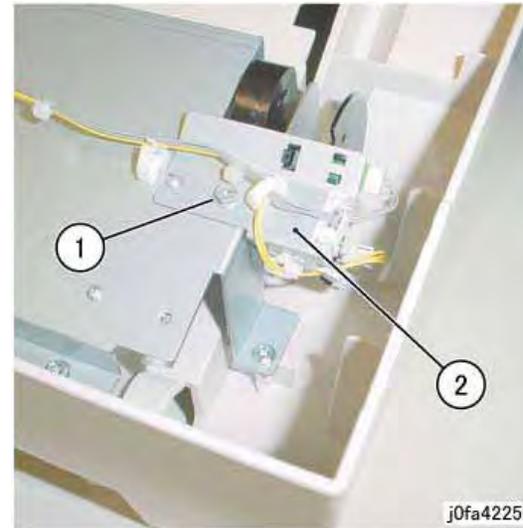
Figure 5 Removing the Stacker Sensor Assembly

10. Remove the Stacker Sensor Assembly (Figure 5):
 - (1) Remove Screw.
 - (2) Remove Stacker Sensor Assembly.
 - (3) Remove Wire from Clamps (5)

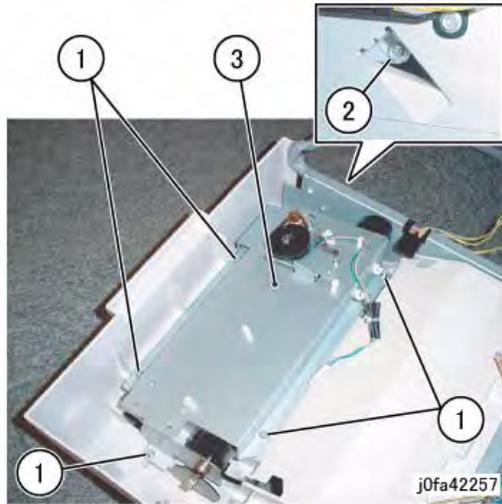
- (1)Remove Self-tapping Screws (5).
- (2)Remove Screw.
- (3)Remove Stacker Assembly.

Figure 6 Removing the Stacker Assembly

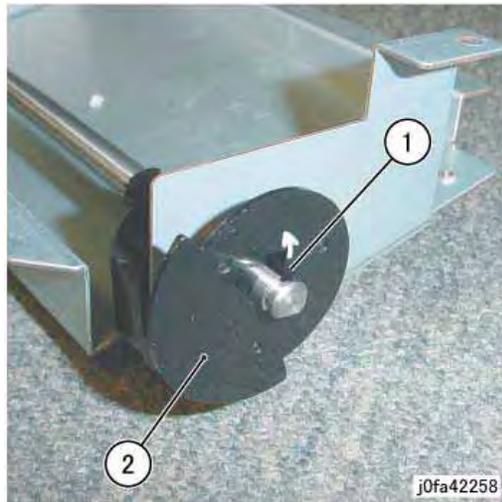
- 12. Remove the Actuator (Figure 7):
- (1)Unhook.
- (2)Remove Actuator.

Figure 7 Removing the Actuator

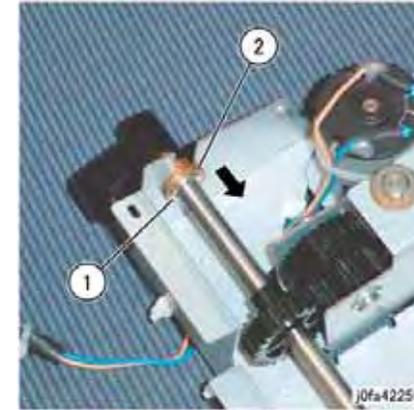
- 13. Move the Bearing (Figure 8):
- (1)Remove E-Clip.
- (2)Move Bearing in the direction of the arrow.

Figure 8 Moving the Bearing

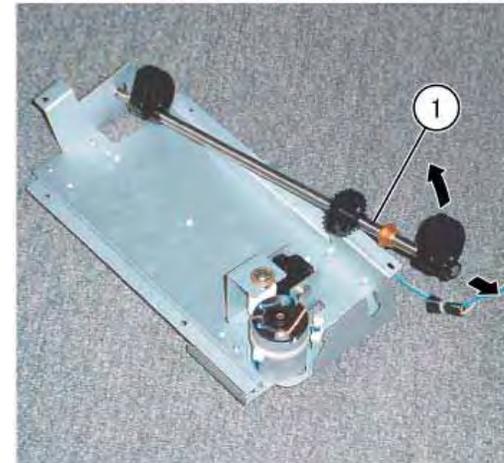
- 14. Remove the Stacker Shaft Assembly (Figure 9):
- (1)Remove Stacker Shaft Assembly in the direction of the arrow.

Figure 9 Removing the Stacker Shaft Assembly

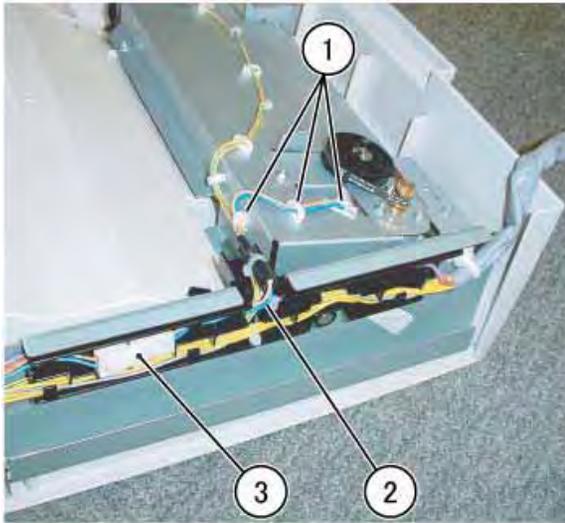
j0fa42261

1. Switch off the power and disconnect the power cord.
2. Remove the Integrated Office Finisher from the machine (REP 12.1).
3. Remove the Rear Cover (PL 22.1)
4. Turn over the Integrated Office Finisher.
5. Remove the Tray Cover (PL 22.2)
6. Disconnect the Connector (Figure 1):
 - (1)Release Clamps (3) and remove the wire.
 - (2)Release Wire from Hook.
 - (3)Disconnect Connector.

Figure 1 Disconnecting the Connector

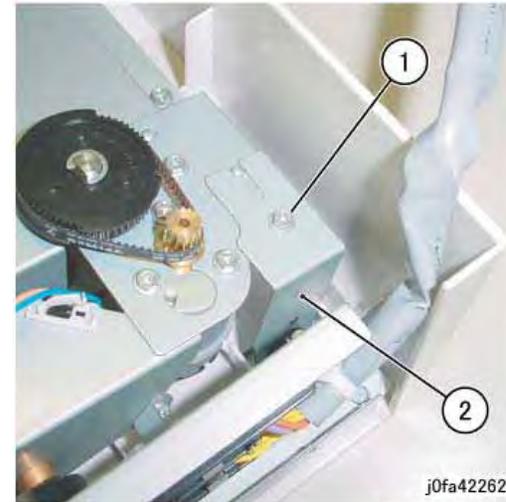
j0fa42262

7. Remove the Bracket (Figure 2):
 - (1)Remove Screw.
 - (2)Remove Bracket.

Figure 2 Removing the Bracket

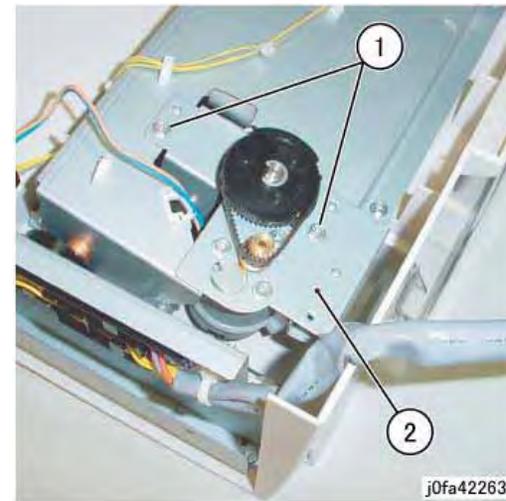
j0fa42263

8. Remove the Stacker Motor Assembly (Figure 3):
 - (1)Remove Screws (2).
 - (2)Remove Stacker Motor Assembly.

Figure 3 Removing the Stacker Motor Assembly

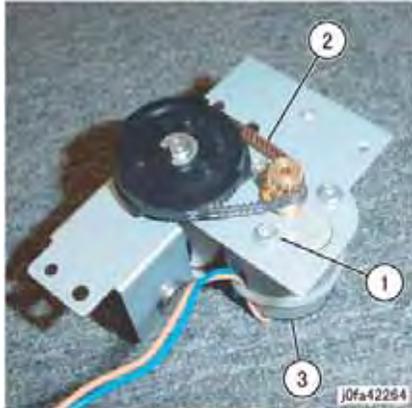
9. Remove the Stacker Motor (Figure 4):
 - (1)Remove Screws (3).
 - (2)Remove Belt from Pulley.

(3)Remove Stacker Motor.

Figure 4 Removing the Stacker Motor)

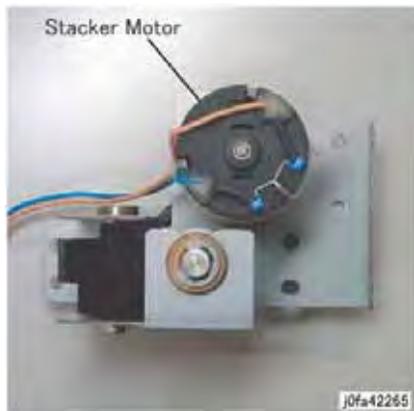
1. Reverse the removal procedure for replacement.
2. Install the Stacker Motor as shown in [Figure 5](#).

Figure 5 Installing the Stacker Motor

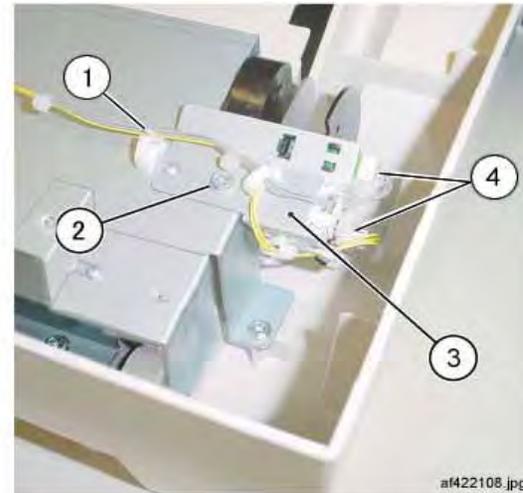
1. Switch off the power and disconnect the power cord.
2. Remove the Integrated Office Finisher from the machine ([REP 12.1](#)).
3. Remove the Rear Cover ([PL 22.1](#))
4. Turn over the Integrated Office Finisher.
5. Remove the Tray Cover ([PL 22.2](#))
6. Remove the Stacker Sensor Assembly ([Figure 1](#)):
 - (1)Release the wire from the Clamp.
 - (2)Remove Screw.
 - (3)Remove Stacker Sensor Assembly.
 - (4)Disconnect the Sensor Connector and remove Sensor from Bracket (5)

Figure 1 Removing the Stacker Stack Sensor Assembly

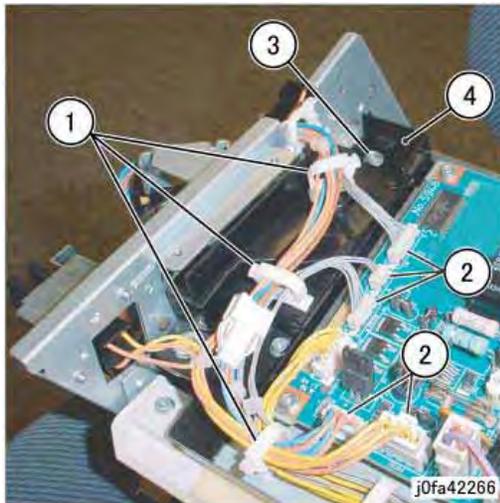
1. Switch off the power and disconnect the power cord.
2. Remove the Integrated Office Finisher from the machine ([REP 12.1](#)).
3. Remove the Inner Front Cover ([PL 22.1](#))
4. Remove the Rear Cover ([PL 22.1](#))
5. Turn over the Integrated Office Finisher.
6. Remove the Bottom Cover ([PL 22.2](#))
7. Remove the Tray Cover ([PL 22.2](#))
8. Remove the Connector Bracket ([Figure 1](#)):
 - (1)Release Clamps (3) and remove the wire.
 - (2)Disconnect Connectors (5).
 - (3)Remove Screws (2).
 - (4)Remove Connector Bracket.

Figure 1 Removing the Connector Bracket

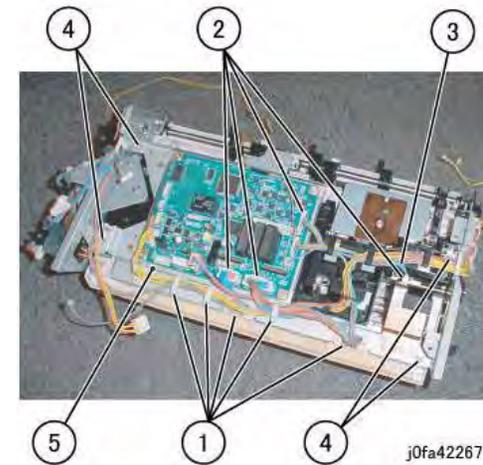
9. Remove the Bottom Plate ([Figure 2](#)):
 - (1)Release Clamps (5) and remove the wire.
 - (2)Disconnect Connectors (8).
 - (3)Remove Wire from Hook.
 - (4)Remove Screws (4).
 - (5)Remove Bottom Plate.

Figure 2 Removing the Bottom Plate

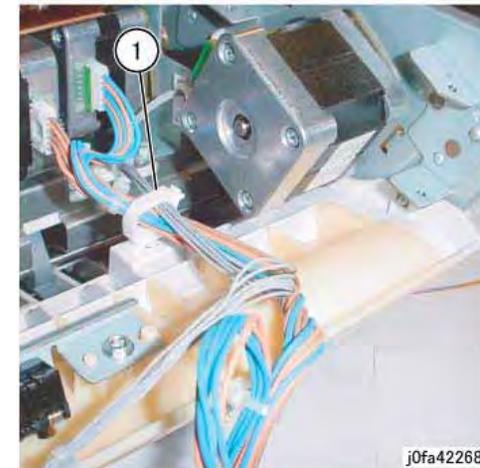
10. Release the Clamp from the wire ([Figure 3](#)):
 - (1)Release Clamp and remove the wire.

Figure 3 Releasing the Clamp

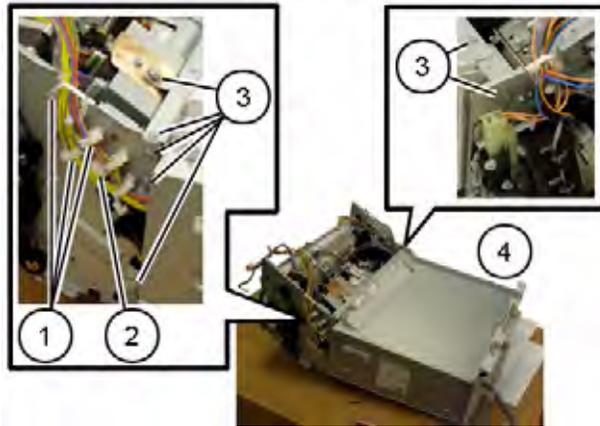
11. Remove the Stacker Tray ([Figure 4](#)):
 - (1)Release wires from Clamps (5)
 - (2)Disconnect the Connector
 - (3)Remove Screws (7)
 - (4)Remove the Stacker Tray

Figure 4 Removing the Stacker Tray

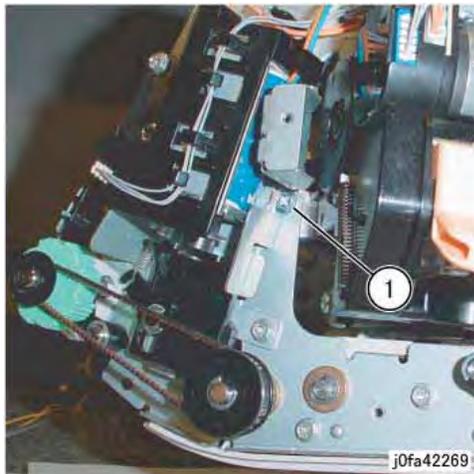
12. Remove the front Self-tapping Screw (Figure 5):
 (1) Remove Self-tapping Screw.

Figure 5 Removing the Self-tapping Screw

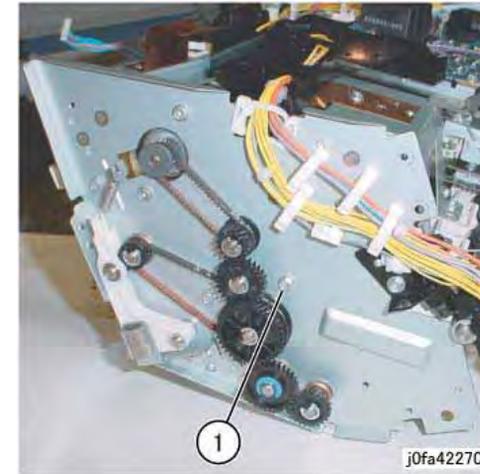
13. Remove the rear Screw (Figure 6):
 (1) Remove Screw.

Figure 6 Removing the Screw

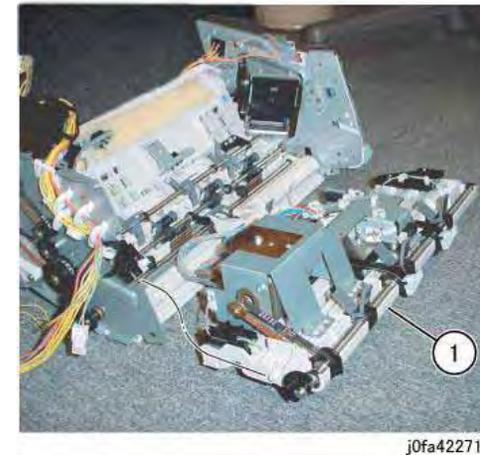
14. Remove the Compiler Assembly (Figure 7):
 (1) Remove Compiler Assembly.

Figure 7 Removing the Compiler Assembly
