WorkCentre 5335 Family Service Documentation

705P01303

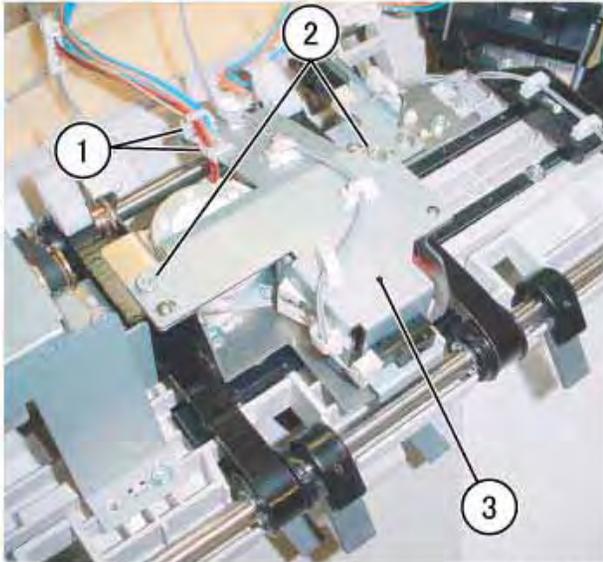
j0fa42272

1. Switch off the power and disconnect the power cord.
2. Remove the Integrated Office Finisher from the machine ([PL 22.1](#)).
3. Remove the Compiler Assembly ([REP 12.20](#))
4. Remove the Bracket Assembly ([Figure 1](#)):
 - (1)Release Clamps (2) and remove the wire.
 - (2)Remove Screws (2).
 - (3)Remove Bracket Assembly.

Figure 1 Removing the Bracket Assembly

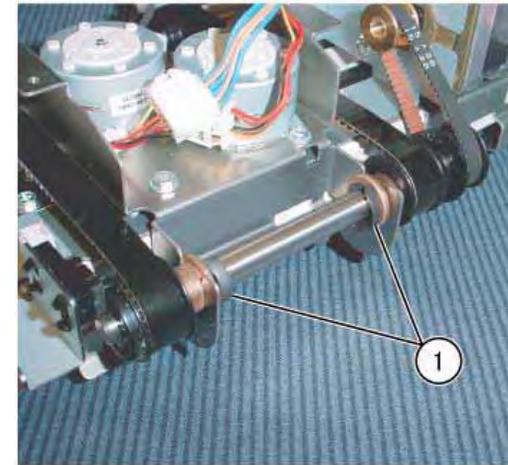
j0fa42273

5. Remove the KL-Clips from the Eject Shaft ([Figure 2](#)):
 - (1)Remove KL-Clips (2).

Figure 2 Removing the KL-Clips

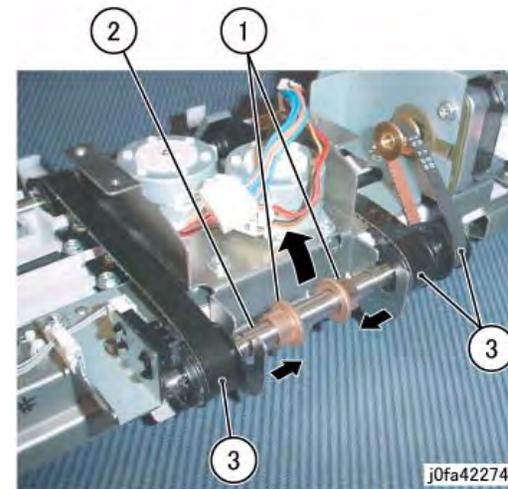
j0fa42274

6. Remove the Eject Shaft from the Front/Rear Tamper Motor Assembly ([Figure 3](#)):
 - (1)Move Bearings (2) in the direction of the arrow.
 - (2)Remove Eject Shaft in the direction of the arrow.
 - (3)Remove Belt from Pulley.

Figure 3 Removing the Eject Shaft

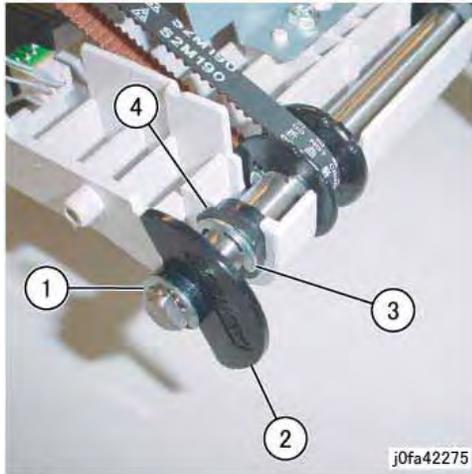
7. Remove the Actuator and the Bearing ([Figure 4](#)):
 - (1)Remove E-Clip.

- (2)Remove Actuator.
- (3)Remove E-Clip.
- (4)Remove Bearing.

Figure 4 Removing the Actuator and Bearing

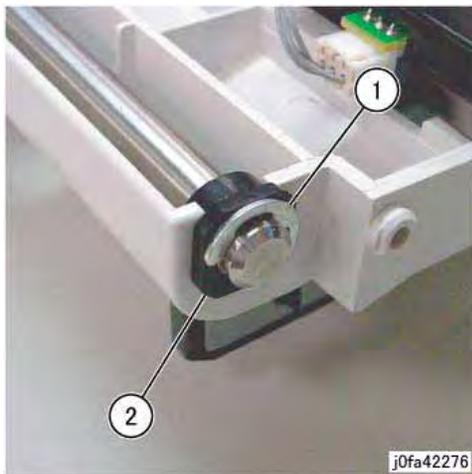
- 8. Remove the Bearing (Figure 5):
- (1)Remove E-Clip.
- (2)Remove Bearing.

Figure 5 Removing the Bearing

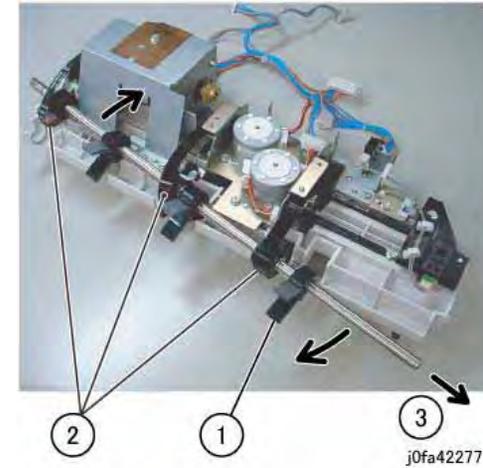
- 9. Remove the Set Clamp Shaft (Figure 6):
- (1)Move Set Clamp Shaft in the direction of the arrow.

- (2)Remove Belts (3) from Pulleys (3).
- (3)Remove Set Clamp Shaft in the direction of the arrow.

Figure 6 Removing the Set Clamp Shaft

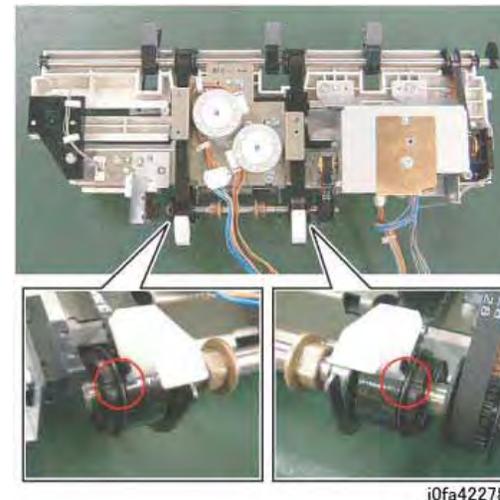
- 1. Reverse the removal procedure for replacement.
- 2. Install and align the Eject Belt with marks on the Pulleys (Figure 7):

Figure 7 Installing the Eject Belt

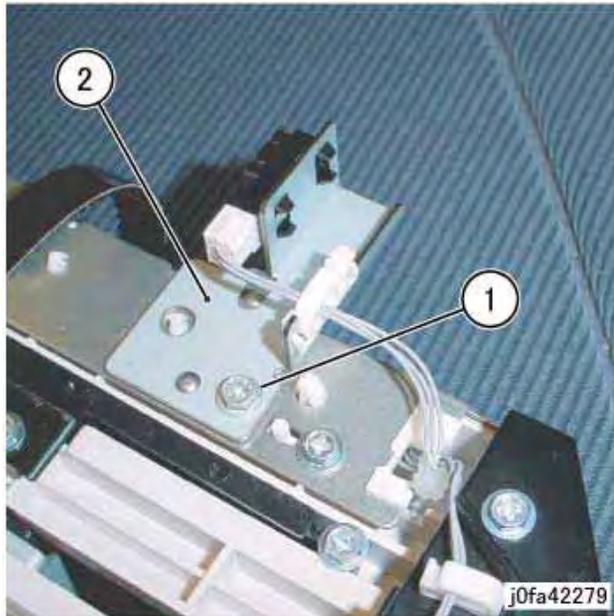
1. Switch off the power and disconnect the power cord.
2. Remove the Integrated Office Finisher from the machine ([PL 22.1](#)).
3. Remove the Compiler Assembly ([REP 12.20](#))
4. Remove the Front/Rear Tamper Motor Assembly ([REP 12.26](#))
5. Move the Eject Home Sensor Assembly ([Figure 1](#)):
(1)Remove Screw.
(2)Move Eject Home Sensor Assembly.

Figure 1 Moving the Eject Home Sensor Assembly (j0fa42279)

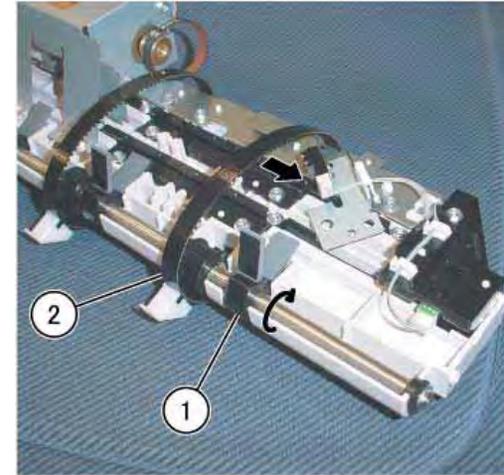
6. Remove the Eject Belt ([Figure 2](#)):
(1)Move the blades of Set Clamp Shaft in the direction of the arrow.
(2)Remove Eject Belt in the direction of the arrow.

Figure 2 Removing the Eject Belt

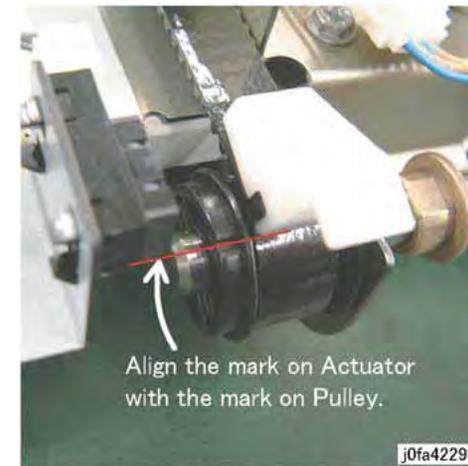
1. Reverse the removal procedure for replacement.
2. Install and align the Eject Belt with marks on the Pulleys ([Figure 3](#)), ([Figure 4](#))

Figure 3 Eject Belt Alignment

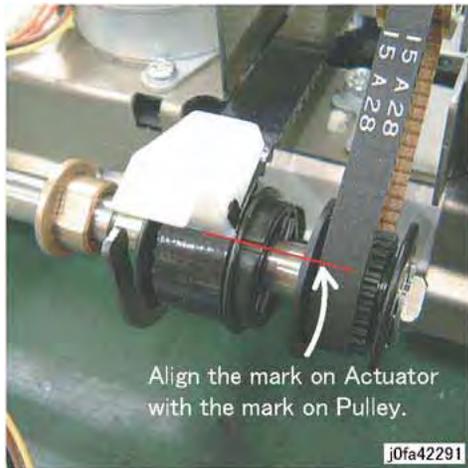
Figure 4 Eject Belt Alignment

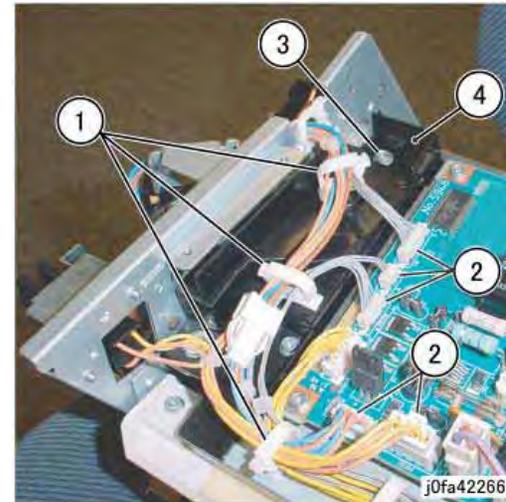
1. Switch off the power and disconnect the power cord.
2. Remove the Integrated Office Finisher from the machine ([REP 12.1](#)).
3. Remove the Inner Front Cover ([PL 22.1](#))
4. Remove the Rear Cover ([PL 22.1](#))
5. Turn over the Integrated Office Finisher.
6. Remove the Bottom Cover ([PL 22.2](#))
7. Remove the Connector Bracket ([Figure 1](#)):
 - (1)Release Clamps (3) and remove the wire.
 - (2)Disconnect Connectors (5).
 - (3)Remove Screws (2).
 - (4)Remove Connector Bracket.

Figure 1 Removing the Connector Bracket

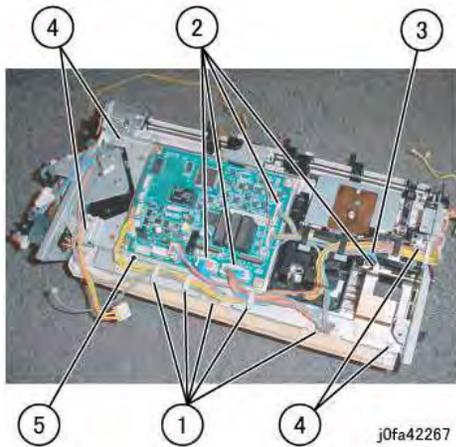
8. Remove the Bottom Plate ([Figure 2](#)):
 - (1)Release Clamps (5) and remove the wire.
 - (2)Disconnect Connectors (8).
 - (3)Remove Wire from Hook.
 - (4)Remove Screws (4).
 - (5)Remove Bottom Plate.

Figure 2 Removing the Bottom Plate

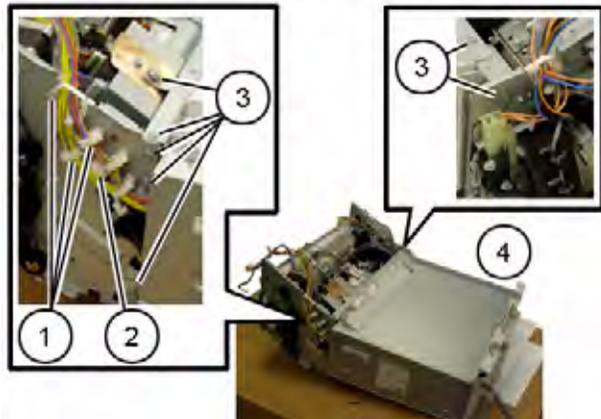
9. Remove the Stacker Tray (Figure 3):
 - (1)Release wires from Clamps (5)
 - (2)Disconnect the Connector
 - (3)Remove Screws (7)
 - (4)Remove the Stacker Tray

Figure 3 Removing the Stacker Tray

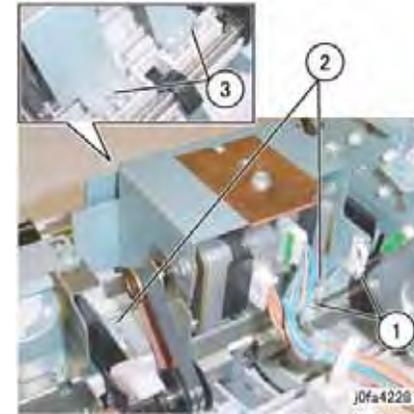
10. Remove the screws securing the Eject/Set Clamp Motor Assembly (Figure 4):
 - (1)Release Clamps (2) and remove the wire.
 - (2)Remove Screws (2).
 - (3)Remove Self-tapping Screws (2).

Figure 4 Removing Screws

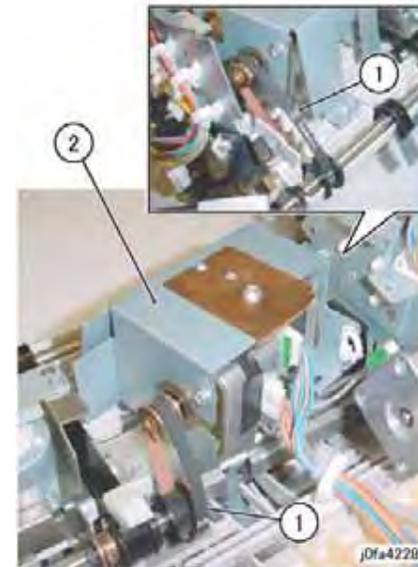
11. Remove the Eject/Set Clamp Motor Assembly (Figure 5):
 - (1)Remove Belts (2) from Pulley.
 - (2)Remove Eject/Set Clamp Motor Assembly.

Figure 5 Removing the Eject/Set Clamp Motor Assembly

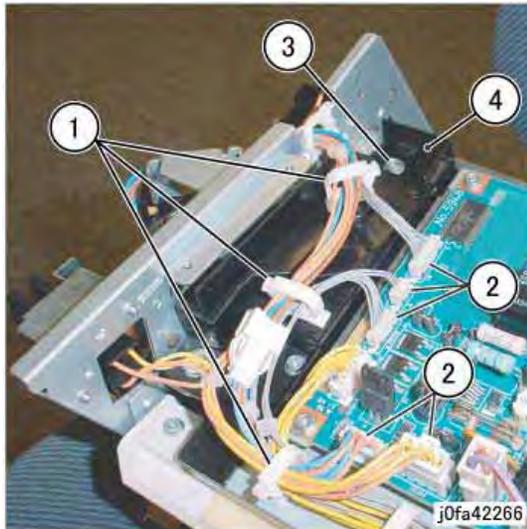
1. Switch off the power and disconnect the power cord.
2. Remove the Integrated Office Finisher from the machine ([REP 12.1](#)).
3. Remove the Inner Front Cover ([PL 22.1](#))
4. Remove the Rear Cover ([PL 22.1](#))
5. Turn over the Integrated Office Finisher.
6. Remove the Bottom Cover ([PL 22.2](#))
7. Remove the Connector Bracket ([Figure 1](#)):
 - (1)Release Clamps (3) and remove the wire.
 - (2)Disconnect Connectors (5).
 - (3)Remove Screws (2).
 - (4)Remove Connector Bracket.

Figure 1 Removing the Connector Bracket

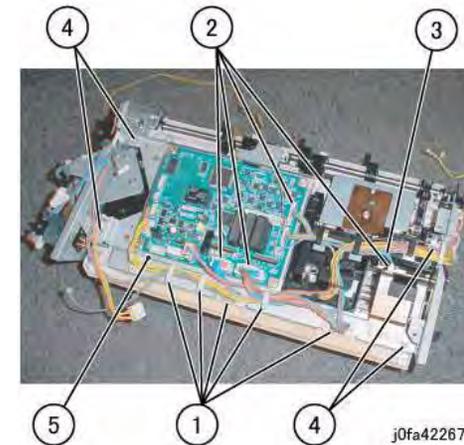
8. Remove the Bottom Plate ([Figure 2](#)):
 - (1)Release Clamps (5) and remove the wire.
 - (2)Disconnect Connectors (8).
 - (3)Remove Wire form Hook.
 - (4)Remove Screw (4).
 - (5)Remove Bottom Plate.

Figure 2 Moving the Bottom Plate

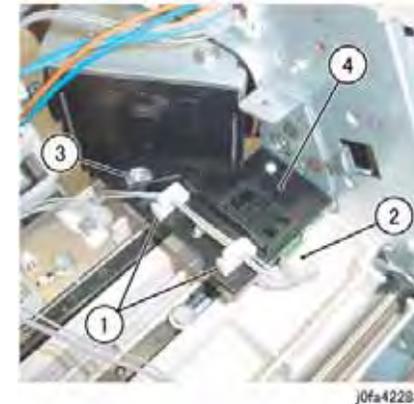
9. Remove the Rear Tamper Home Sensor Assembly ([Figure 3](#)):
 - (1)Release Clamps (2) and remove the wire.
 - (2)Remove Self-tapping Screw.
 - (3)Move Rear Tamper Home Sensor Assembly in order to disconnect the connector.

Figure 3 Removing the Rear Tamper Home Sensor Assembly

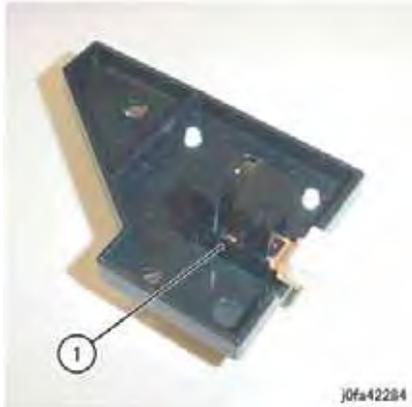
10. Remove the Rear Tamper Home Sensor ([Figure 4](#)):
 - (1)Remove Rear Tamper Home Sensor from the bracket.

Figure 4 Removing the Rear Tamper Home Sensor

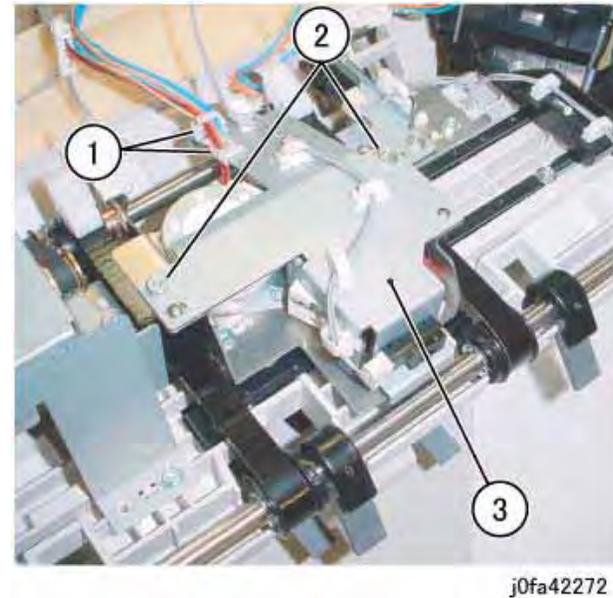
1. Switch off the power and disconnect the power cord.
2. Remove the Integrated Office Finisher from the machine ([PL 22.1](#)).
3. Remove the Compiler Assembly ([REP 12.20](#))
4. Remove the Bracket Assembly ([Figure 1](#)):
 - (1)Release Clamps (2) and remove the wire.
 - (2)Remove Screws (2).
 - (3)Remove Bracket Assembly.

Figure 1 Removing the Bracket Assembly

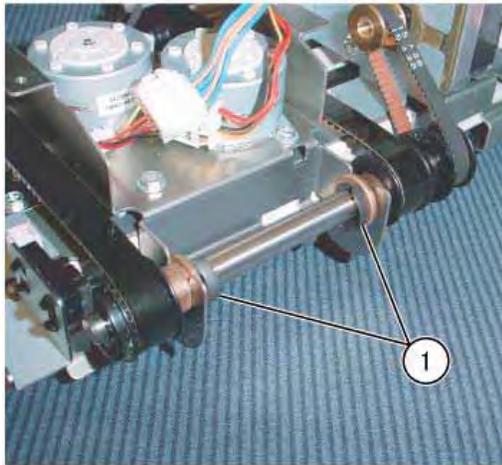
j0fa42273

5. Remove the KL-Clips from the Eject Shaft ([Figure 2](#)):
 - (1)Remove KL-Clips (2).

Figure 2 Removing the KL-Clips

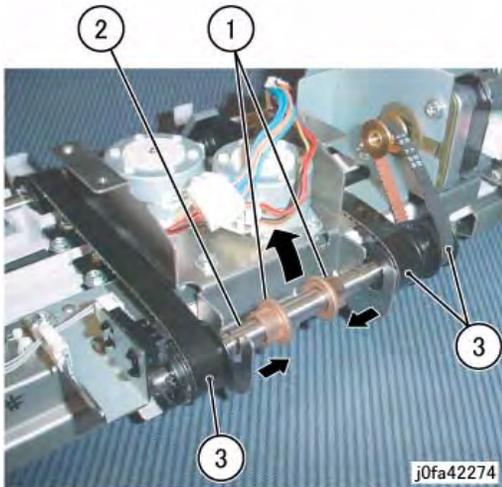
j0fa42274

6. Remove the Eject Shaft from the Front/Rear Tamper Motor Assembly (Figure 3):
 - (1) Move Bearings (2) in the direction of the arrow.
 - (2) Remove Eject Shaft in the direction of the arrow.
 - (3) Remove Belt from Pulley.

Figure 3 Removing the Eject Shaft

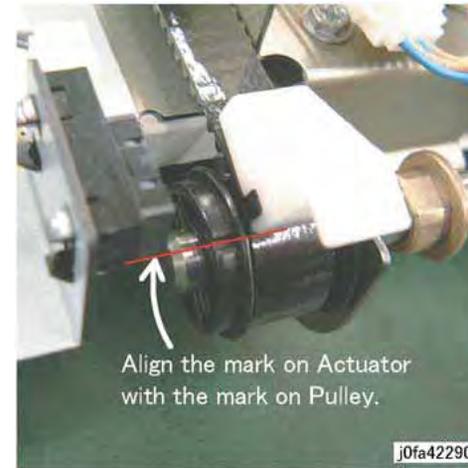
2. Install and align the Eject Belt with marks on the Pulleys (Figure 4) (Figure 5):

Figure 4 Align Eject Belt

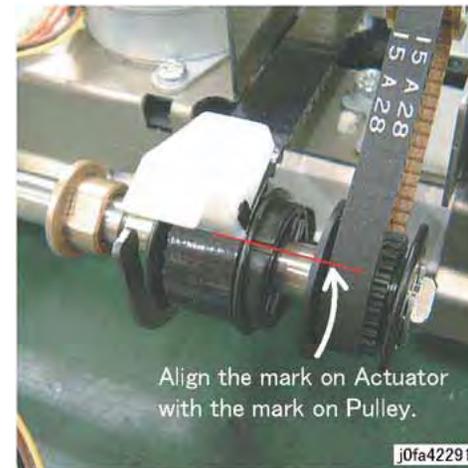
Figure 5 Align Eject Belt

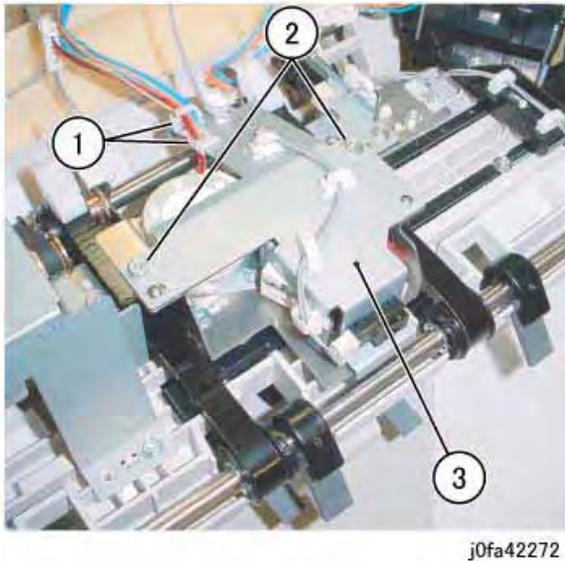
1. Switch off the power and disconnect the power cord.
2. Remove the Integrated Office Finisher from the machine ([PL 22.1](#)).
3. Remove the Compiler Assembly ([REP 12.20](#))
4. Remove the Bracket Assembly ([Figure 1](#)):
(1)Release Clamps (2) and remove the wire.
(2)Remove Screws (2).
(3)Remove Bracket Assembly.

Figure 1 Removing the Bracket Assembly

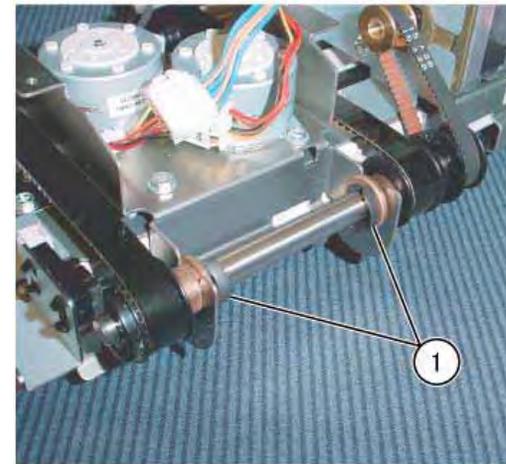
5. Remove the KL-Clips from the Eject Shaft ([Figure 2](#)):
(1)Remove KL-Clips (2).

Figure 2 Removing the KL-Clips

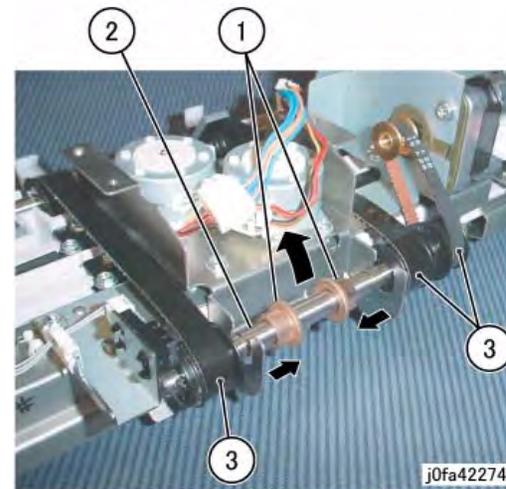
6. Remove the Eject Shaft from the Front/Rear Tamper Motor Assembly ([Figure 3](#)):
(1)Move Bearings (2) in the direction of the arrow.
(2)Remove Eject Shaft in the direction of the arrow.
(3)Remove Belt from Pulley.

Figure 3 Removing the Eject Shaft

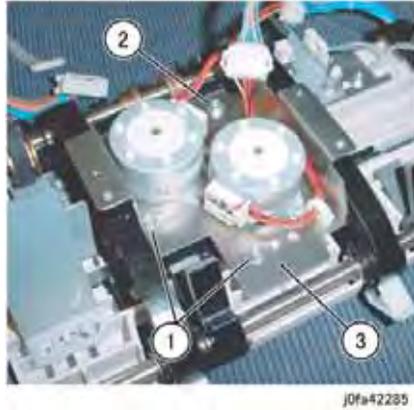
(2)Remove Screw.

(3)Remove Front/Rear Tamper Motor Assembly.

Figure 4 Removing the Front/Rear Tamper Motor Assembly

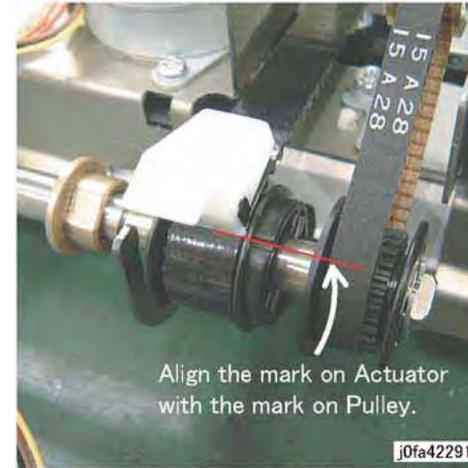
Figure 6 Align Eject Belt

1. Reverse the removal procedure for replacement.
2. Install and align the Eject Belt with marks on the Pulleys (Figure 5) (Figure 6):

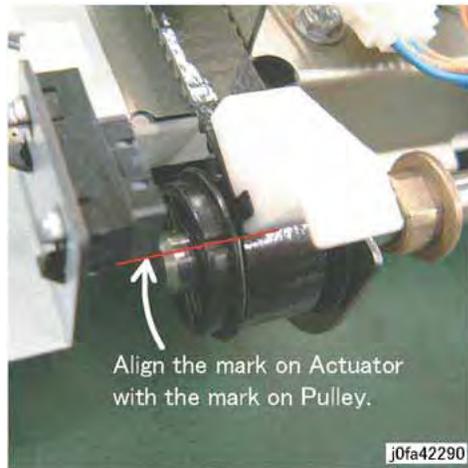
Figure 5 Align Eject Belt

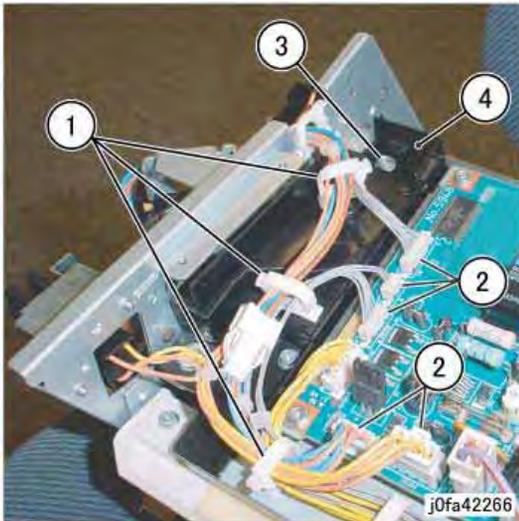
1. Switch off the power and disconnect the power cord.
2. Remove the Integrated Office Finisher from the machine (REP 12.1).
3. Remove the Inner Front Cover (PL 22.1)
4. Remove the Rear Cover (PL 22.1)
5. Turn over the Integrated Office Finisher.
6. Remove the Bottom Cover (PL 22.2)
7. Remove the Connector Bracket (Figure 1):
 - (1)Release Clamps (3) and remove the wire.
 - (2)Disconnect Connectors (5).
 - (3)Remove Screws (2).
 - (4)Remove Connector Bracket.

Figure 1 Removing the Connector Bracket

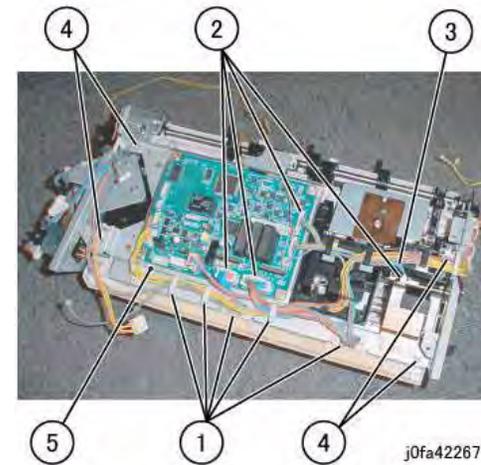
8. Remove the Bottom Plate (Figure 2):
 - (1)Release Clamps (5) and remove the wire.
 - (2)Disconnect Connectors (8).
 - (3)Remove Wire from Hook.
 - (4)Remove Screws (4).
 - (5)Remove Bottom Plate.

Figure 2 Removing the Bottom Plate

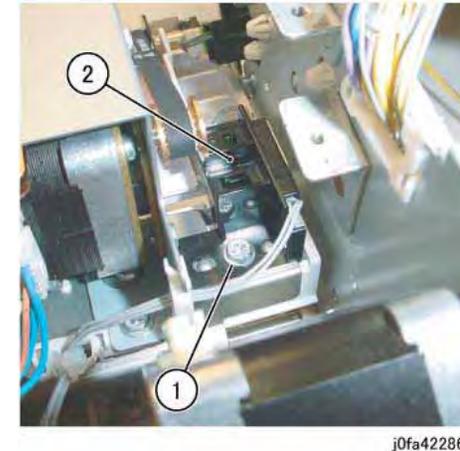
9. Remove the Front Tamper Home Sensor Assembly (Figure 3):
 - (1)Remove Screw.
 - (2)Remove Front Tamper Home Sensor Assembly.

Figure 3 Removing the Front Tamper Home Sensor Assembly

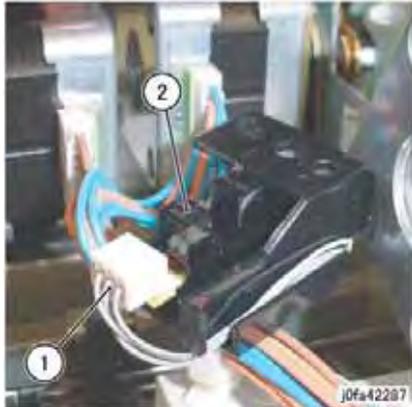
10. Remove the Front Tamper Home Sensor Assembly (Figure 4):
 - (1)Disconnect Connector.
 - (2)Remove Front Tamper Home Sensor Assembly.

Figure 4 Removing the Front Tamper Home Sensor

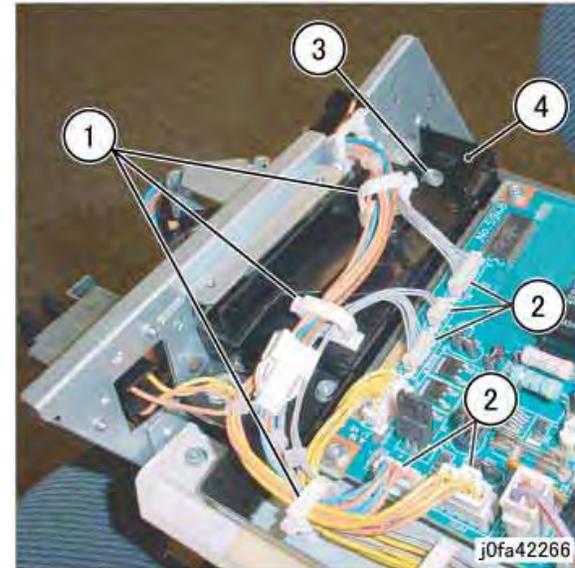
1. Switch off the power and disconnect the power cord.
2. Remove the Integrated Office Finisher from the machine ([REP 12.1](#)).
3. Turn over the Integrated Office Finisher.
4. Remove the Bottom Cover ([PL 22.2](#))
5. Remove the Connector Bracket ([Figure 1](#)):
 - (1)Release Clamps (3) and remove the wire.
 - (2)Disconnect Connectors (5).
 - (3)Remove Screws (2).
 - (4)Remove Connector Bracket.

Figure 1 Removing the Connector Bracket

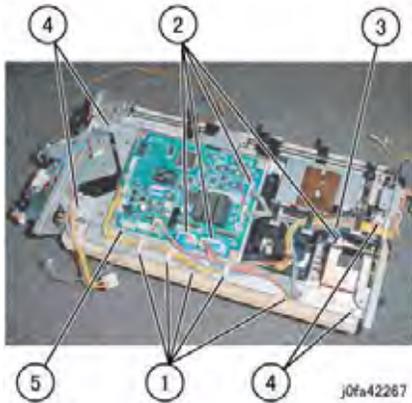
6. Remove the Bottom Plate ([Figure 2](#)):
 - (1)Release Clamps (5) and remove the wire.
 - (2)Disconnect Connectors (8).
 - (3)Remove Wire from Hook.
 - (4)Remove Screws (4).
 - (5)Remove Bottom Plate.

Figure 2 Removing the Bottom Plate

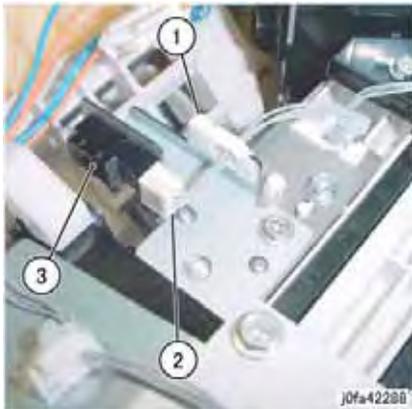
7. Remove the Eject Home Sensor (Figure 3):
 - (1)Release Clamp and remove the wire.
 - (2)Disconnect Connector.
 - (3)Remove Eject Home Sensor from the bracket.

Figure 3 Removing the Eject Home Sensor

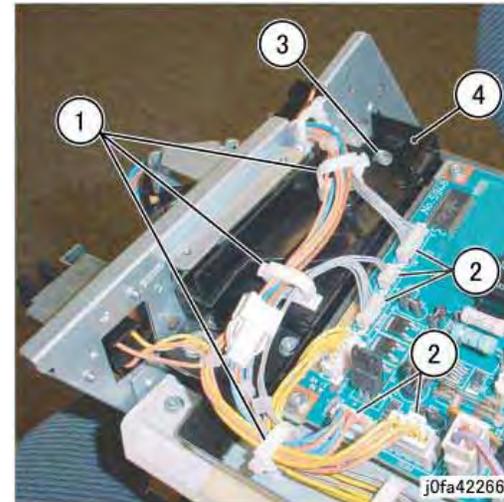
1. Switch off the power and disconnect the power cord.
2. Remove the Integrated Office Finisher from the machine ([REP 12.1](#)).
3. Remove the Inner Front Cover ([PL 22.1](#))
4. Remove the Rear Cover ([PL 22.1](#))
5. Turn over the Integrated Office Finisher.
6. Remove the Bottom Cover ([PL 22.2](#))
7. Remove the Connector Bracket (Figure 1):
 - (1)Release Clamps (3) and remove the wire.
 - (2)Disconnect Connectors (5).
 - (3)Remove Screws (2).
 - (4)Remove Connector Bracket.

Figure 1 Removing the Connector Bracket

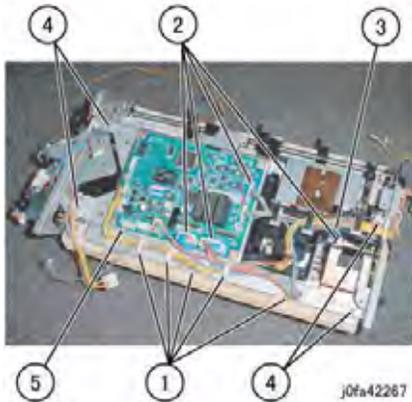
8. Remove the Bottom Plate (Figure 2):
 - (1)Release Clamps (5) and remove the wire.
 - (2)Disconnect Connectors (8).
 - (3)Remove Wire from Hook.
 - (4)Remove Screws (4).
 - (5)Remove Bottom Plate.

Figure 2 Removing the Bottom Plate

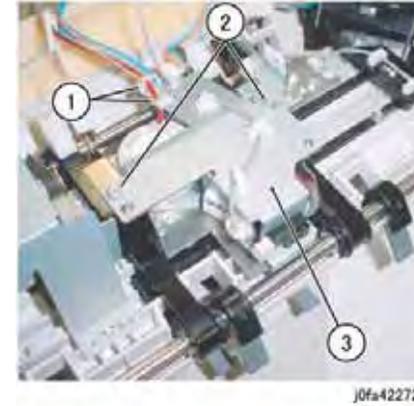
Figure 4 Removing the Bracket Assembly

10. Remove the Bracket Assembly (Figure 4):
 - (1)Release Clamps (2) and remove the wire.
 - (2)Remove Screws (2).
 - (3)Remove Bracket Assembly.

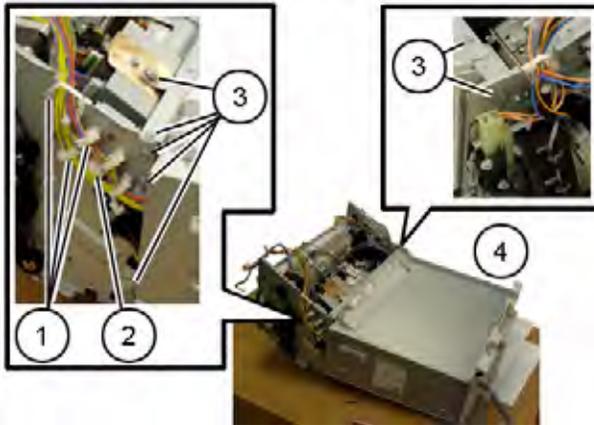
9. Remove the Stacker Tray (Figure 3):
 - (1)Release wires from Clamps (5)
 - (2)Disconnect the Connector
 - (3)Remove Screws (7)
 - (4)Remove the Stacker Tray

Figure 3 Removing the Stacker Tray

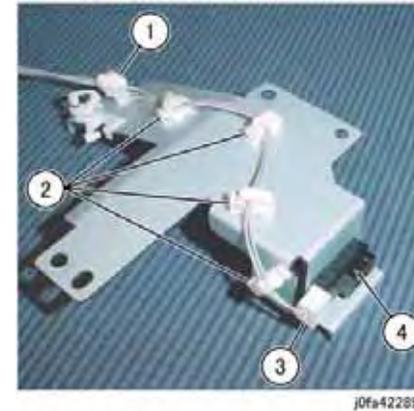
11. Remove the Stack Height Sensor (Figure 5):
 - (1)Remove Clamp.
 - (2)Release Clamps (4) and remove the wire.
 - (3)Disconnect Connector.
 - (4)Remove Stack Height Sensor from the bracket.

Figure 5 Removing the Stack Height Sensor

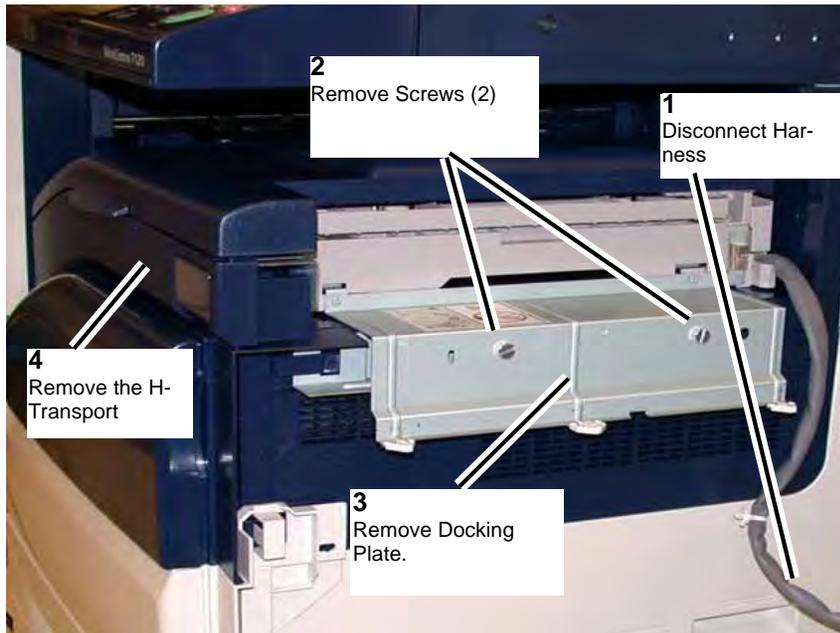
1. Switch off the power and disconnect the power cord.
2. Undock the Finisher Assembly ([REP 13.5](#)).
3. Move the H-Transport Assembly ([Figure 1](#)).

Figure 1 Removing the Docking Bracket

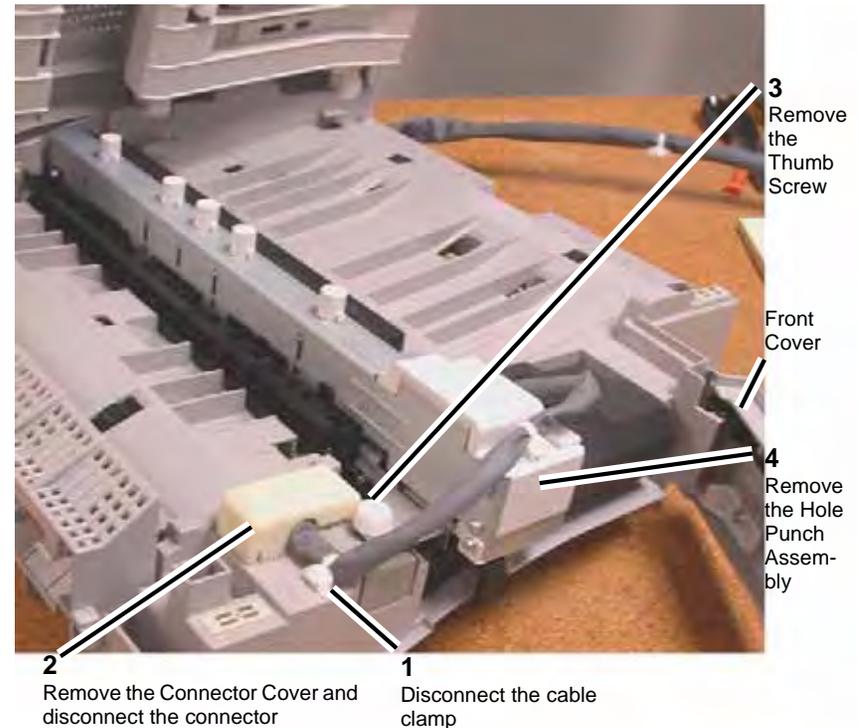
1. Switch off the power and disconnect the power cord.
2. Open the H-Transport Top Cover and hold it open.
3. Open the H-Transport Front Cover.
4. Remove the Hole Punch Assembly ([Figure 1](#)).

Figure 1 Removing the Hole Punch Assembly

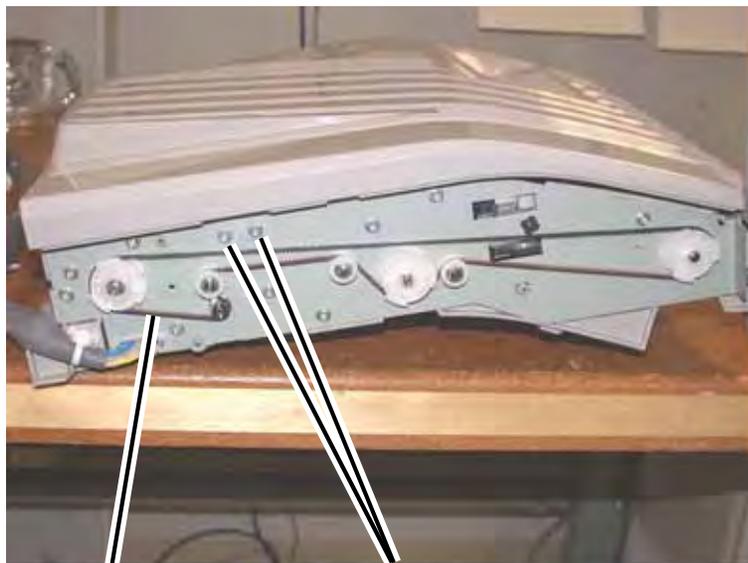
1. Switch off the power and disconnect the power cord.
2. Remove the H-Transport Assembly ([REP 13.1](#)).
3. Remove the screws (2) on the H-Transport Rear Cover and remove the Cover.
4. Loosen the screws (2) on the Tension Bracket ([Figure 1](#)).
5. Remove the Belt.

2 Remove the Belt
1 Loosen the screws (2)

Figure 1 Removing the H-Transport Belt

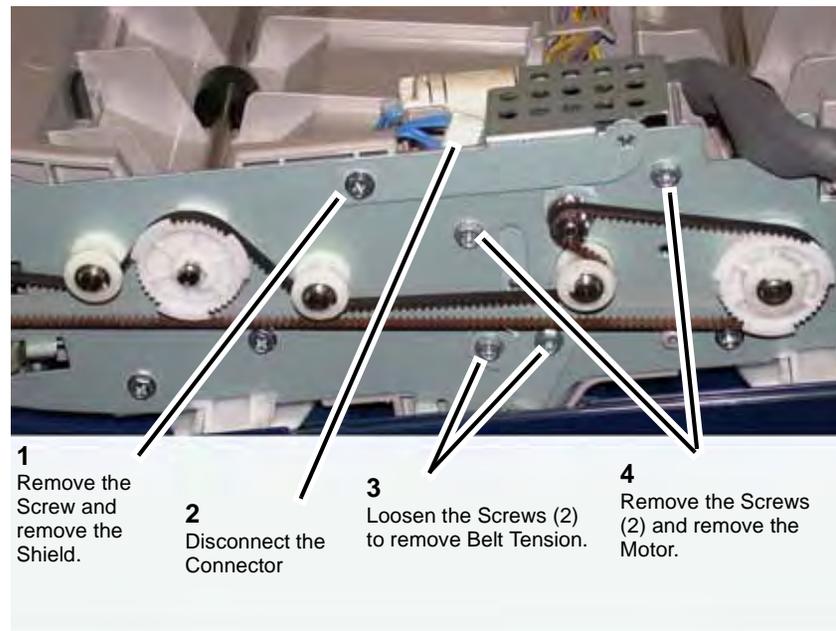
1. Switch off the power and disconnect the power cord.
2. Remove the H-Transport Assembly ([REP 13.1](#)).
3. Remove the H-Transport Rear Cover.
4. Place the H-Transport top down on a work surface.
5. Remove the H-Transport motor ([Figure 1](#)).

1 Remove the Screw and remove the Shield.
2 Disconnect the Connector
3 Loosen the Screws (2) to remove Belt Tension.
4 Remove the Screws (2) and remove the Motor.

Figure 1 Removing the H-Transport Drive Motor

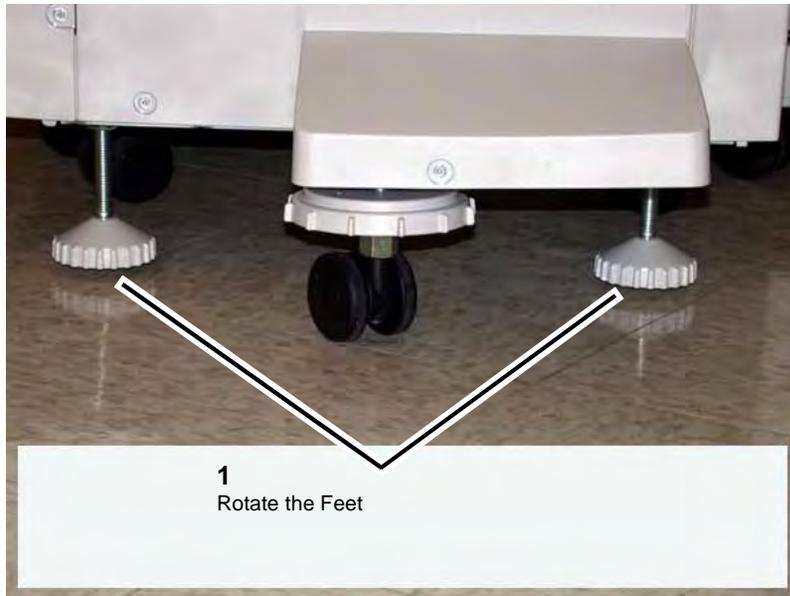
3. Rotate the Feet (2) to free the Finisher. (Figure 1)

Figure 1 Finisher Feet

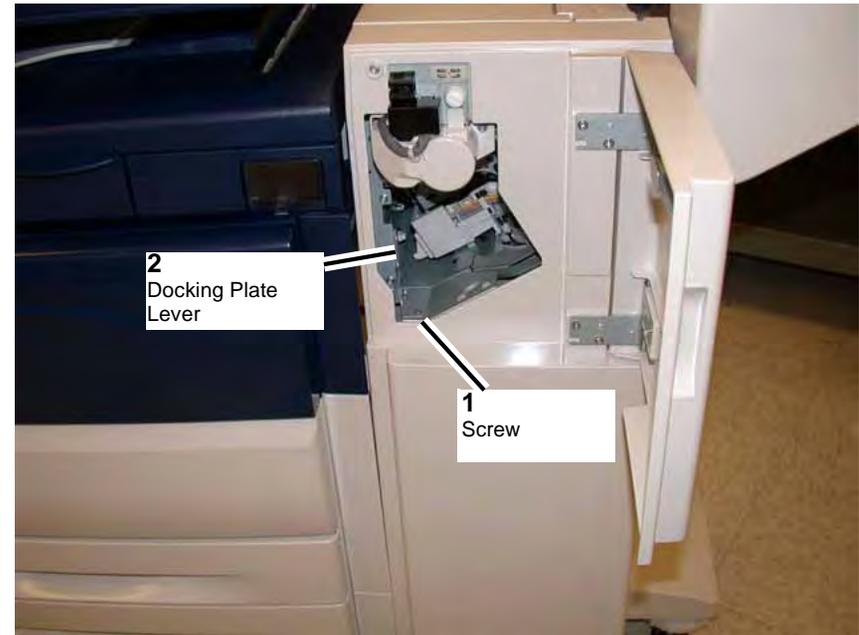
4. Open the Front Door of the Finisher.
5. Release the Screw that secures the Docking Plate and detach the Finisher.
 - (1) Remove the Screw.
 - (2) Pull the Docking Plate Lever towards you and detach the Finisher.(Figure 2).

Figure 2 Finisher Lever

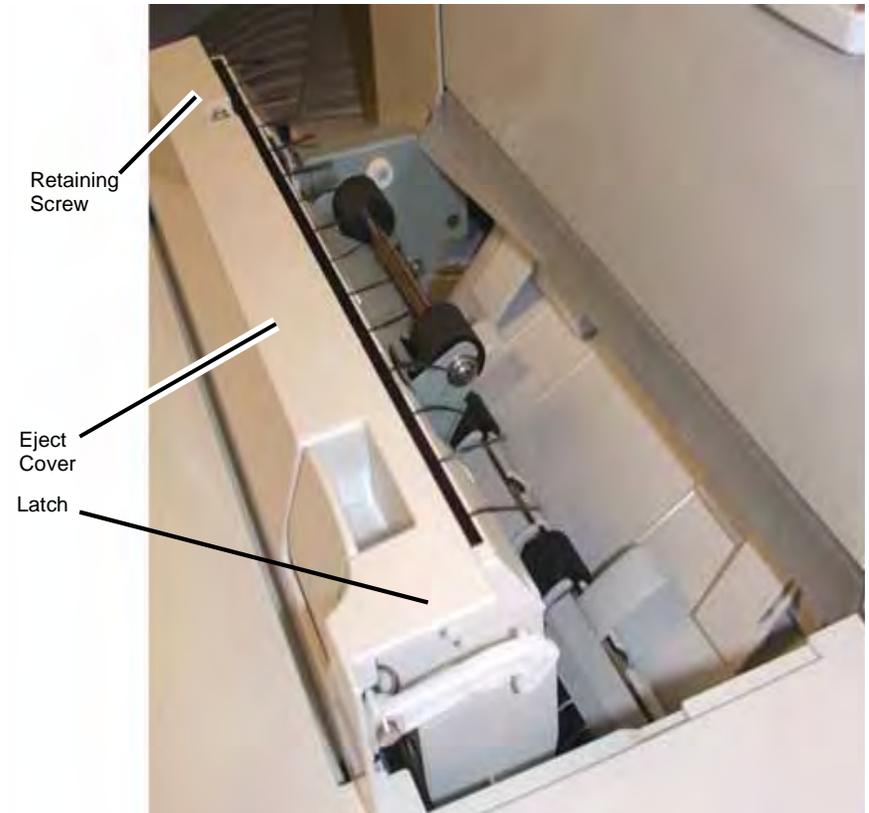
1. Switch off the power and disconnect the power cord.
2. Remove the Eject Cover ([Figure 1](#)).
 - (1) Unlatch the Eject Cover, and move it to the left.
 - (2) Remove the Retaining Screw (1).
 - (3) Push the Latch through the hole in the Cover.
 - (4) Remove the Cover by moving it to the left.

Figure 1 Removing the Eject Cover

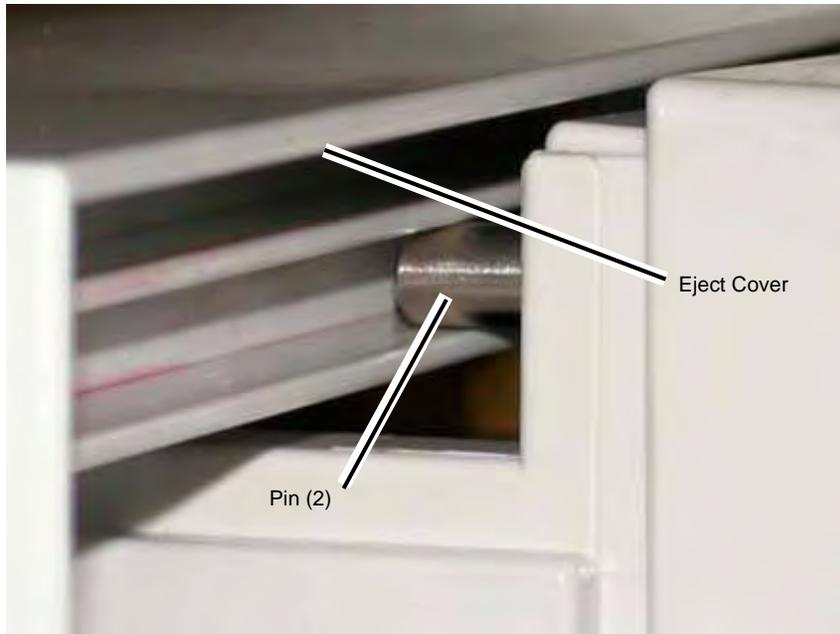
1. Align the Eject Cover with the Pins (2) on both sides, and slide it to the right (Figure 2).

NOTE: The left side of the Cover is now captured by the Pins and cannot be lifted up.

Figure 2 Aligning the Eject Cover

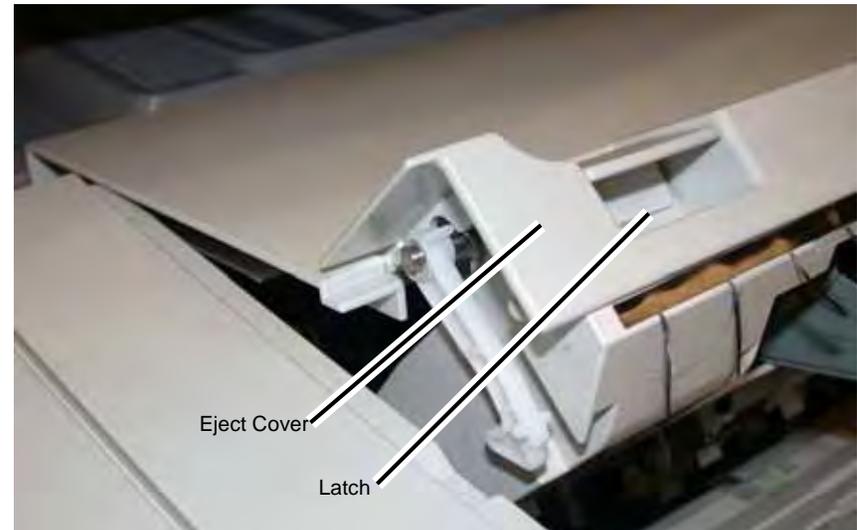
2. Position the Eject Cover so that the Latch is inserted in the hole (Figure 3).

NOTE: The Latch must be outside the hole.

Figure 3 Inserting the Latch through the hole in the Cover

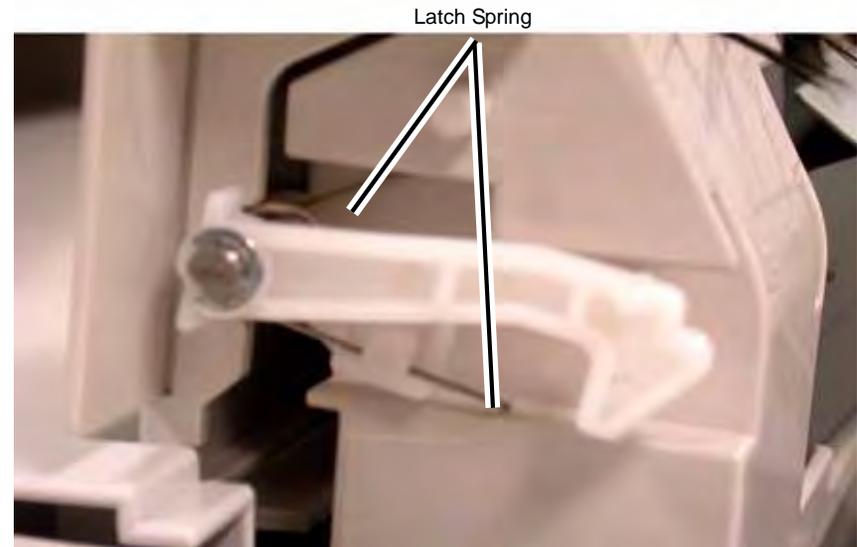
3. Place the Latch Spring in the position shown (Figure 4).

Figure 4 Positioning the Latch Spring

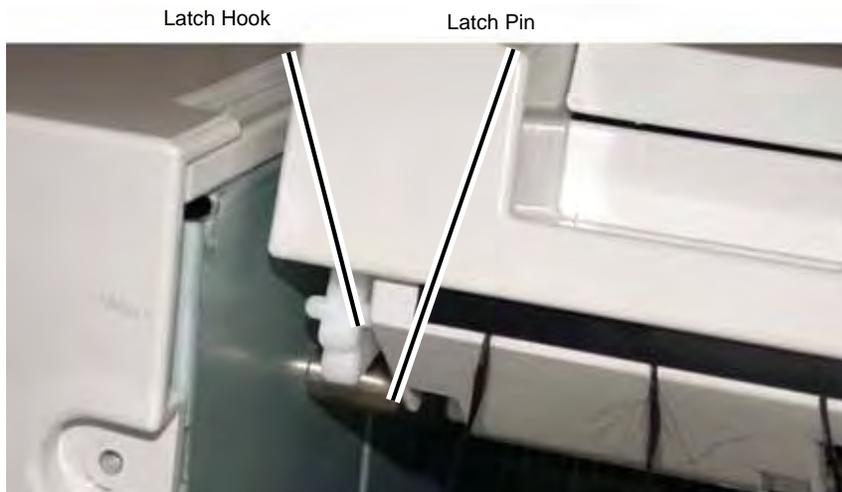
4. Make sure the Latch Hook and Latch Pin are positioned as shown (Figure 5).

Figure 5 Positioning the Latch Hook and Latch Pin

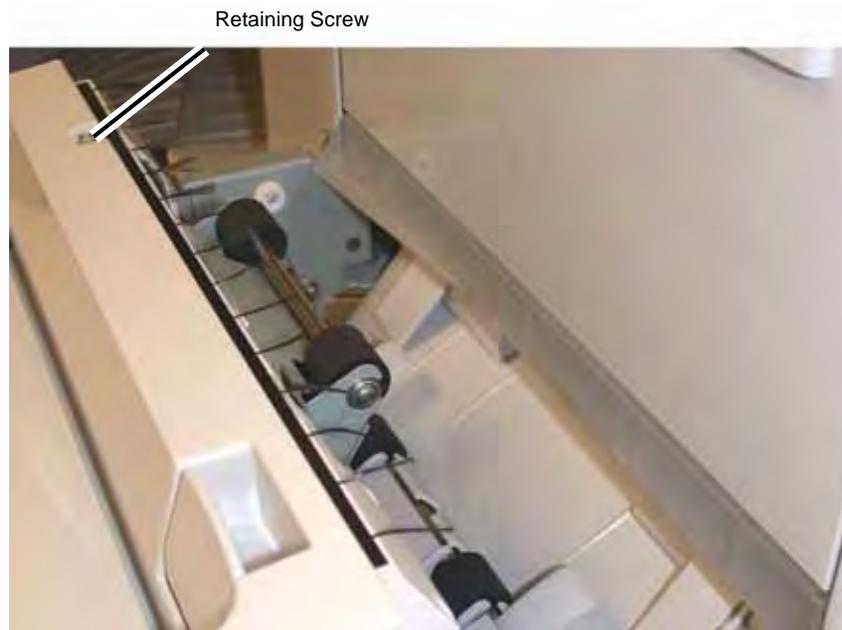
5. Install the Retaining Screw (1) (Figure 6).

Figure 6 Installing the Retaining Screw

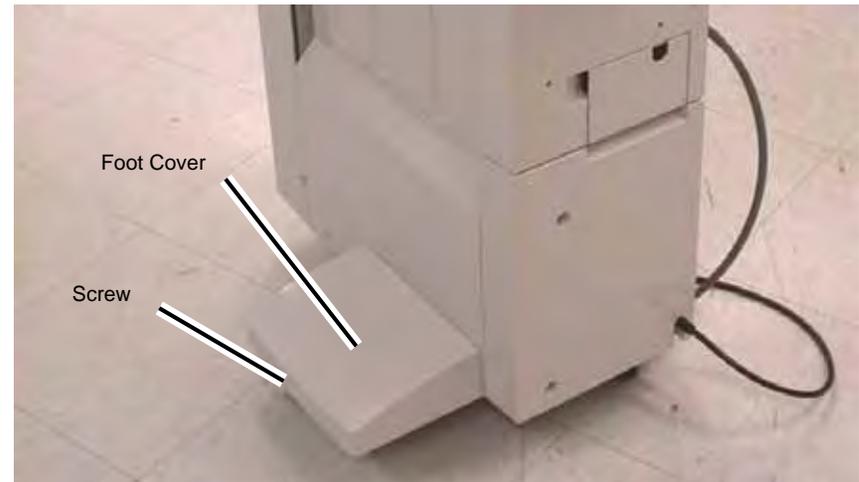
1. Switch off the power and disconnect the power cord.
2. Remove the Screw (1) (Figure 1).
3. Remove the Foot Cover.

Figure 1 Removing the Foot Cover

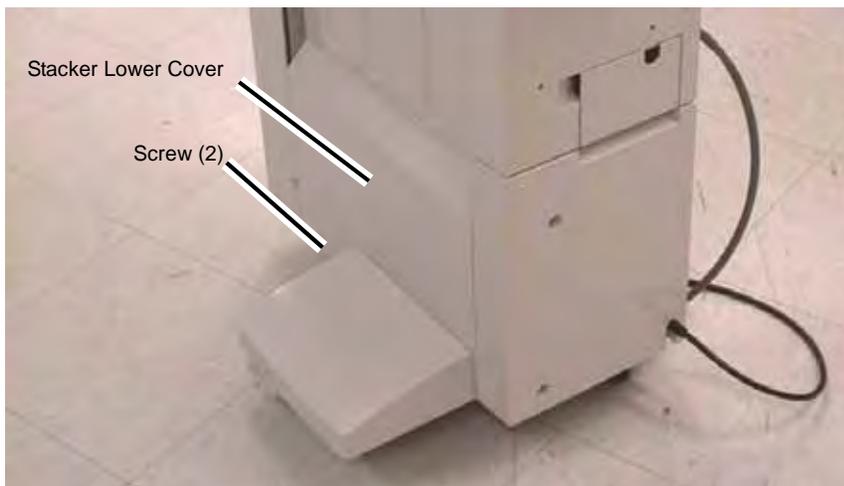
1. Switch off the power and disconnect the power cord.
2. Remove the Foot Cover ([REP 13.10](#)).
3. Remove the Screws (2) ([Figure 1](#)).
4. Remove the Stacker Lower Cover.

Figure 1 Removing the Stacker Lower Cover

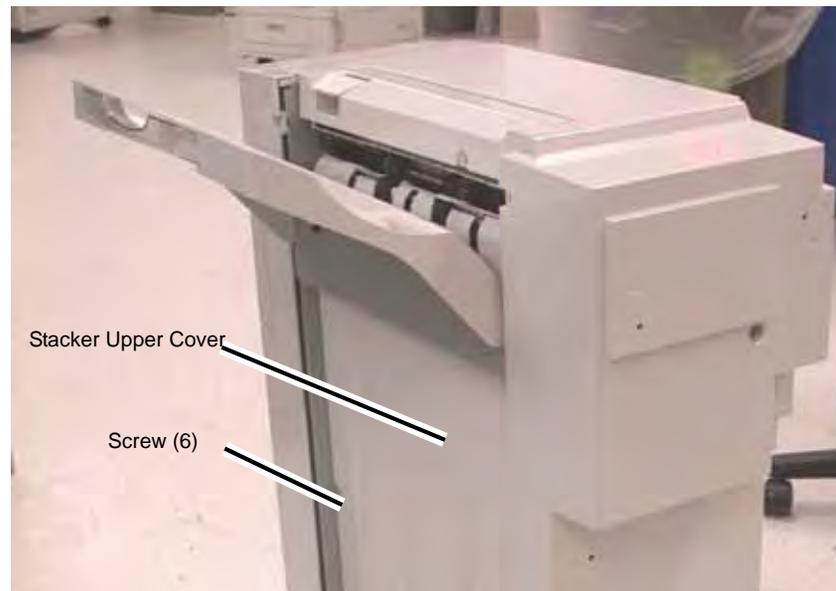
1. Switch off the power and disconnect the power cord.
2. Remove the Stacker Tray ([REP 13.20](#)).
3. Remove the Stacker Lower Cover ([REP 13.11](#)).
4. Remove the Screws (6) ([Figure 1](#)).
5. Remove the Stacker Upper Cover.

Figure 1 Removing the Stacker Upper Cover

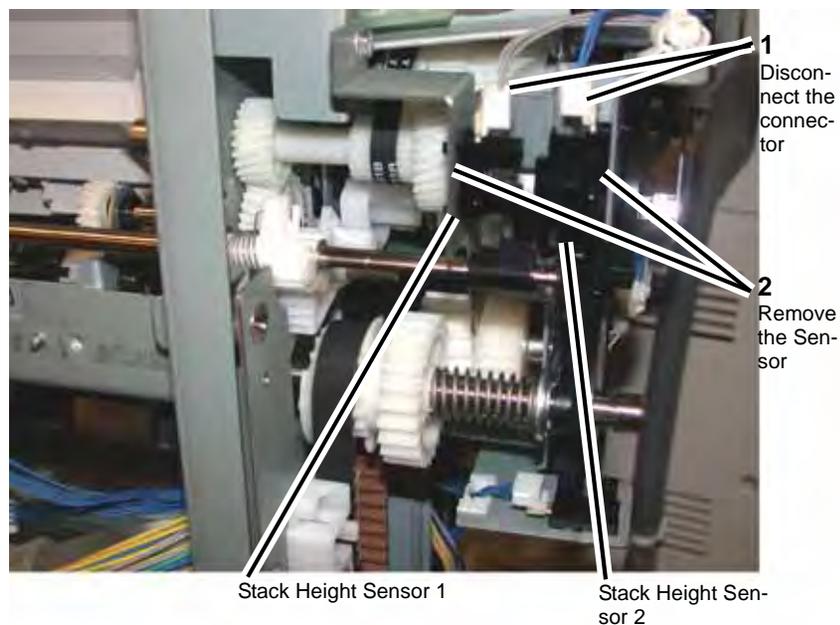
1. Switch off the power and disconnect the power cord.
2. Remove the Rear Upper Cover ([REP 13.7](#)).
3. Remove the Stack Height Sensor 1 or 2 ([Figure 1](#)).
 - (1) Disconnect the connector.
 - (2) Remove the Sensor.

Figure 1 Removing the Stack Height Sensor 1 or 2

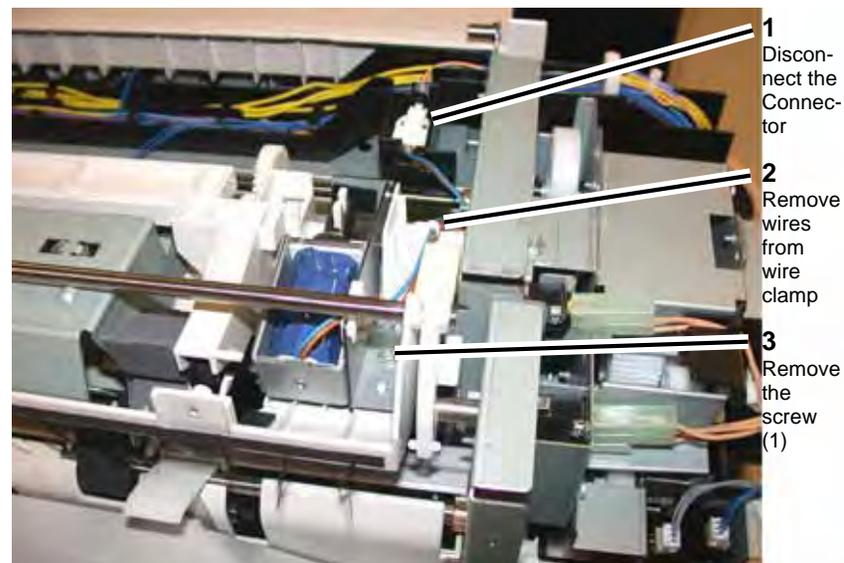
1. Switch off the power and disconnect the power cord.
2. Remove the Eject Cover ([REP 13.9](#)).
3. Remove the Sub Paddle Solenoid Assembly ([Figure 1](#)).
 - (1) Disconnect the connector.
 - (2) Remove the wires from the wire clamps
 - (3) Remove the screw (1) from the Sub Paddle Solenoid Assembly.
 - (4) Remove the Sub Paddle Solenoid Assembly.

Figure 1 Removing the Sub Paddle Solenoid Assembly
