WorkCentre 5335 Family Service Documentation

705P01303

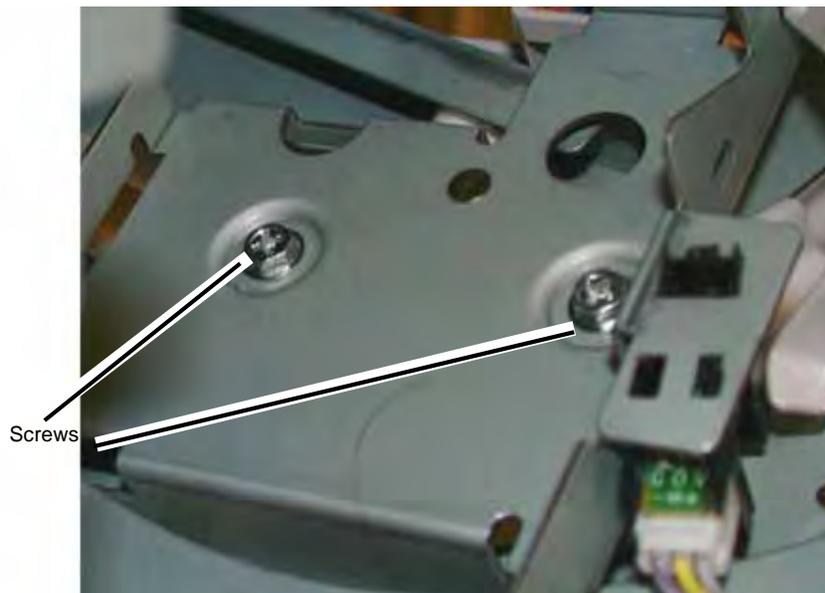
1. Switch off the power and disconnect the power cord.
2. Remove the Finisher Stapler Assembly ([REP 13.16](#)).
3. Remove the Screws (2) ([Figure 1](#)).

Figure 1 Removing the Screws

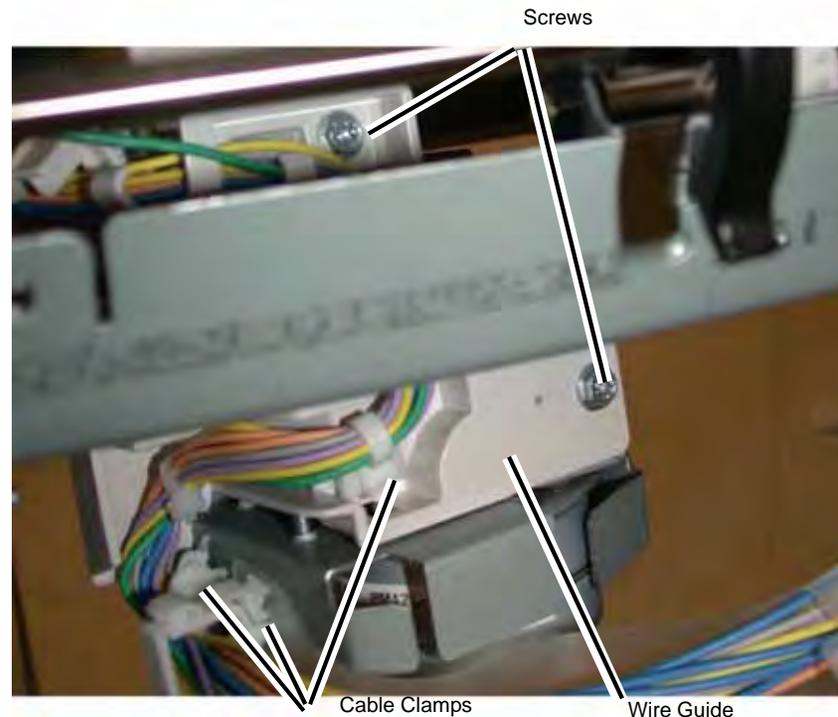
4. Remove the Wire Guide ([Figure 2](#)).
 - (1) Pull out the Cable Clamps (3), and remove the wires from the Wire Guide.
 - (2) Remove the Screws (2).
 - (3) Remove the Wire Guide.

Figure 2 Removing the Wire Guide

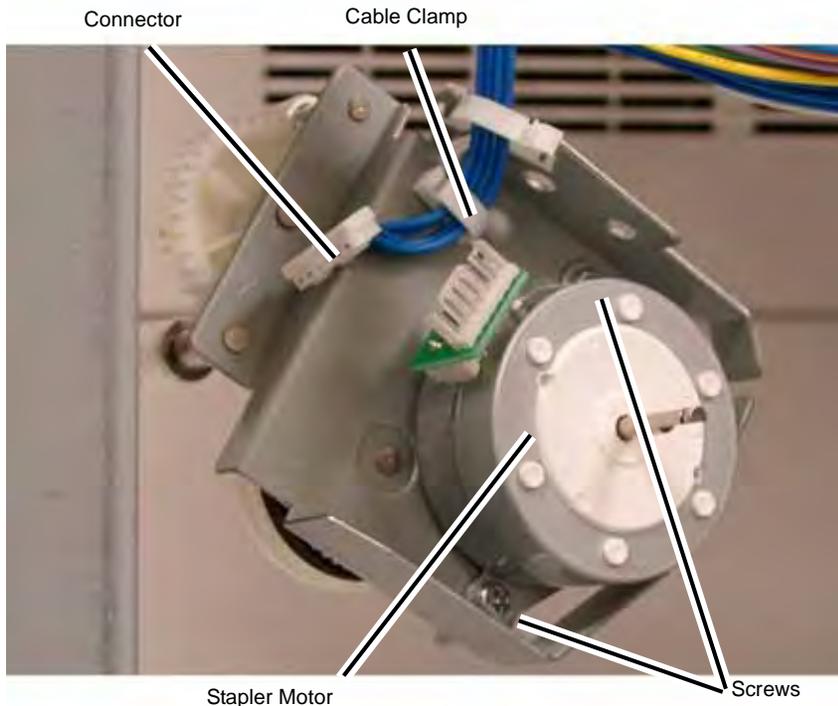
5. Remove the Stapler Motor ([Figure 3](#)).
 - (1) Remove the wires from the Cable Clamp.
 - (2) Disconnect the Connector.
 - (3) Remove the Screws (2).
 - (4) Remove the Stapler Motor.

Figure 3 Removing the Stapler Motor

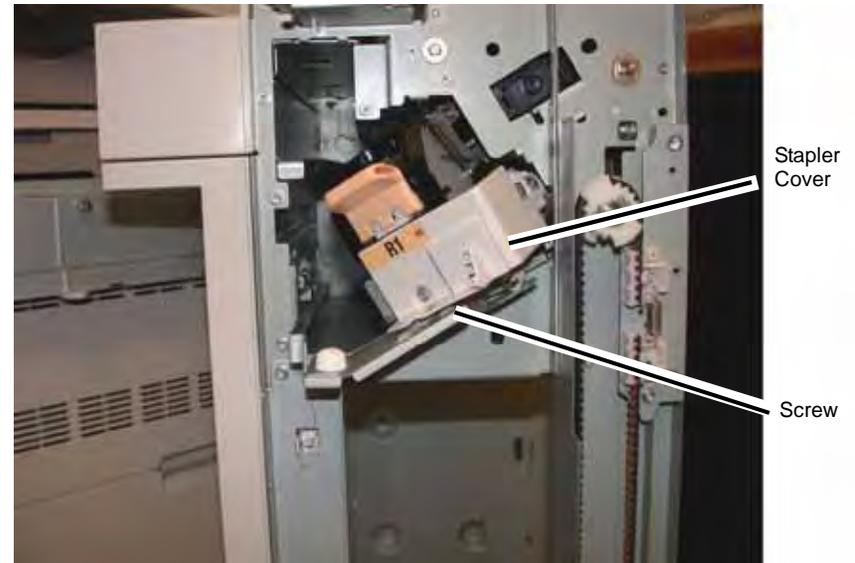
1. Switch off the power and disconnect the power cord.
2. Remove the Creaser Knife Assembly (REP 13.18).
3. Remove the Front Cover Assembly (REP 13.6).
4. Remove the Stapler Cover (Figure 1).
 - (1) Remove the Screw.
 - (2) Remove the Stapler Cover.

Figure 1 Removing the Stapler Cover

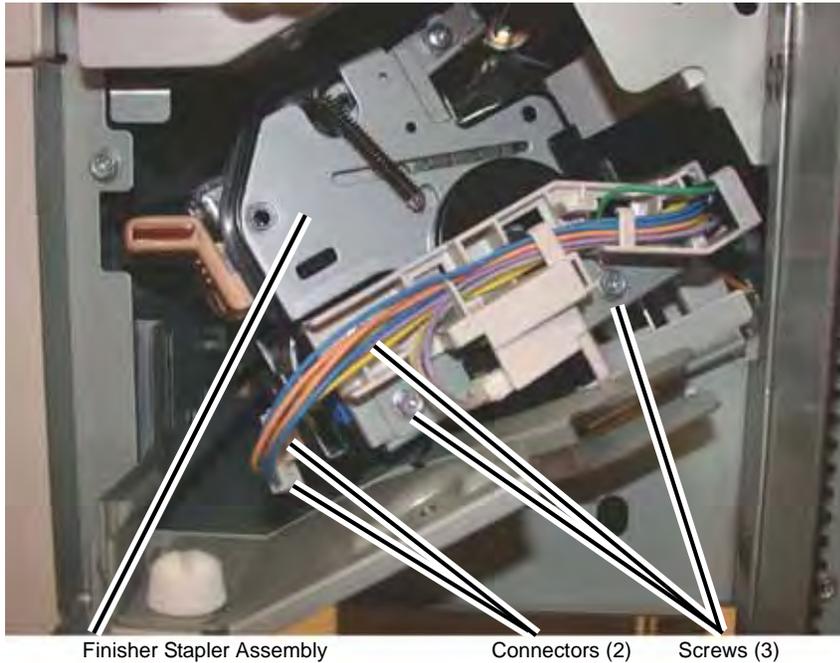
5. Remove the Finisher Stapler Assembly (Figure 2).
 - (1) Disconnect the Connectors (2).
 - (2) Remove the Screws (3).
 - (3) Remove the Finisher Stapler Assembly.

Figure 2 Removing the Finisher Stapler Assembly

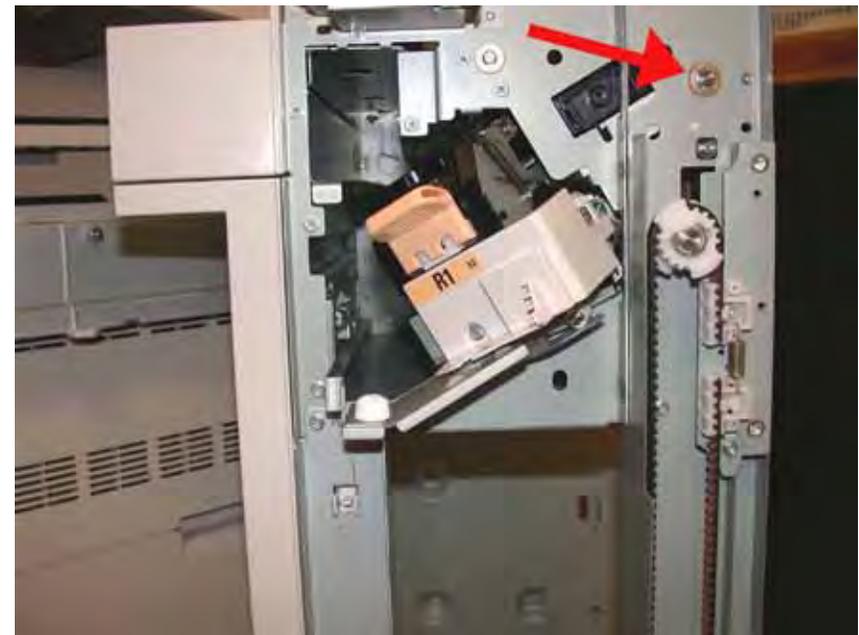
1. Switch off the power and disconnect the power cord.
2. Undock the Finisher ([REP 13.5](#)).
3. Remove the Front Cover ([REP 13.6](#)).
4. Remove the Rear Upper Cover ([REP 13.7](#)).
5. Remove the Foot Cover ([REP 13.10](#)).
6. Remove the Stacker Lower Cover ([REP 13.11](#)).
7. Remove the Stacker Tray ([REP 13.20](#)).
8. Remove the Stacker Upper Cover ([REP 13.12](#)).
9. Remove the Eject Cover ([REP 13.9](#)).
10. Preparing to remove the Eject Roller Shaft ([Figure 1](#)).

Figure 1 Removing the E-ring and brass bearing

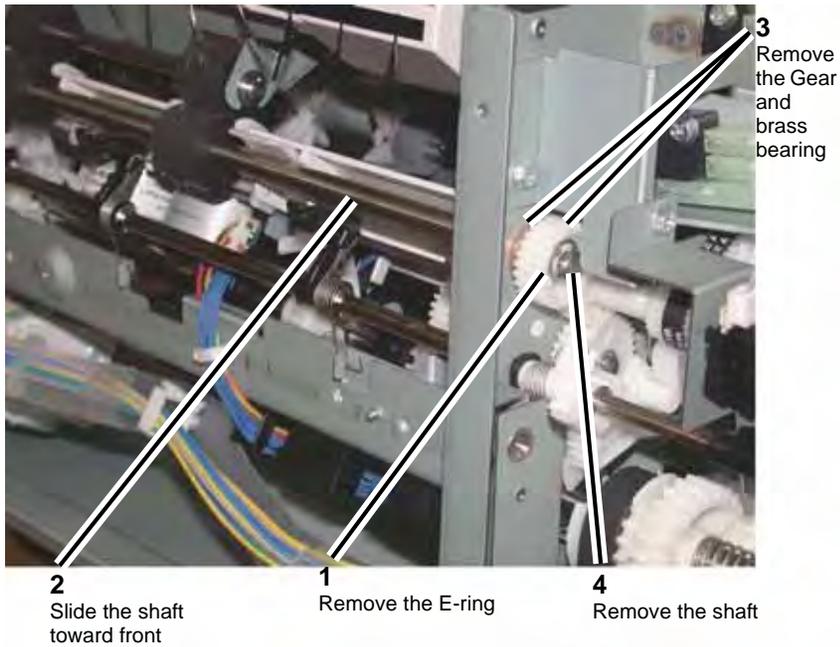
11. Remove the Eject Roll Shaft ([Figure 2](#)).
 - (1) Remove the E-ring and brass bearing from the front of the shaft.
 - (2) Remove the E-ring,
 - (3) Slide the Eject Roller shaft toward the front.
 - (4) Remove the Gear, and brass bushing.
 - (5) Remove the Eject Roll from the Finisher.

Figure 2 Removing the Eject Roll Shaft

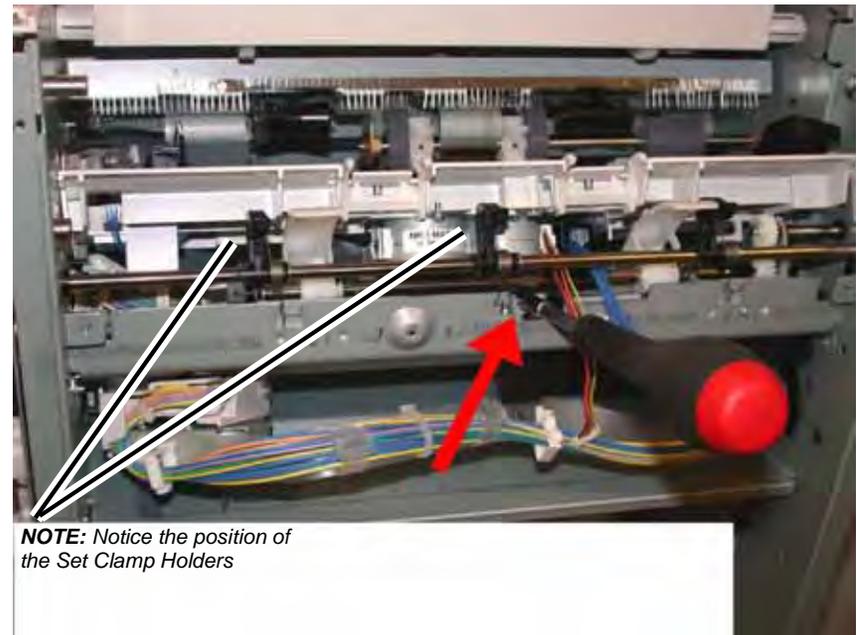
12. Remove the Compiler Tray screw (Figure 3).

Figure 3 Removing the Compiler Tray screw

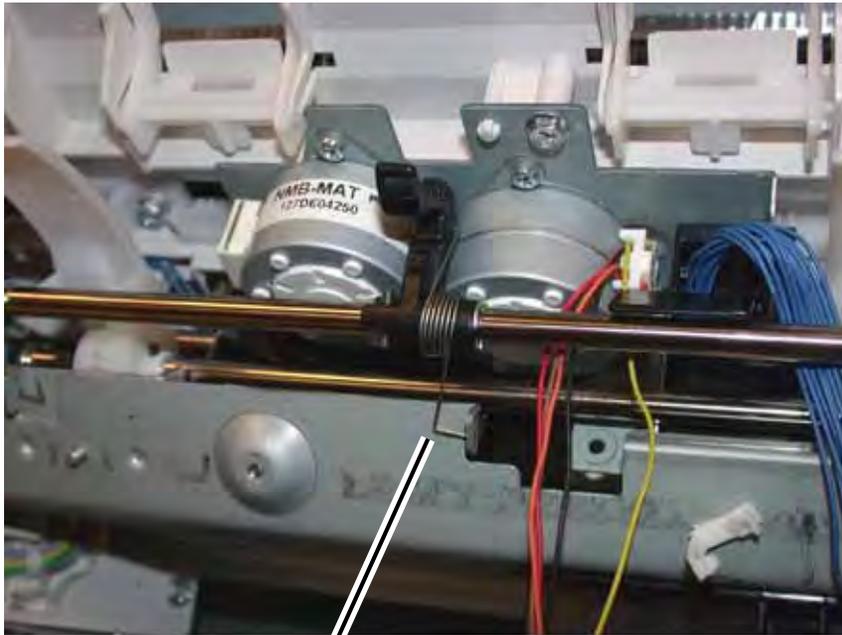
13. Disconnect the springs from the Set Clamp Holders (3) (Figure 4).

Disconnect spring from the Holders (3)

Figure 4 Disconnecting the Set Clamp Holder Springs

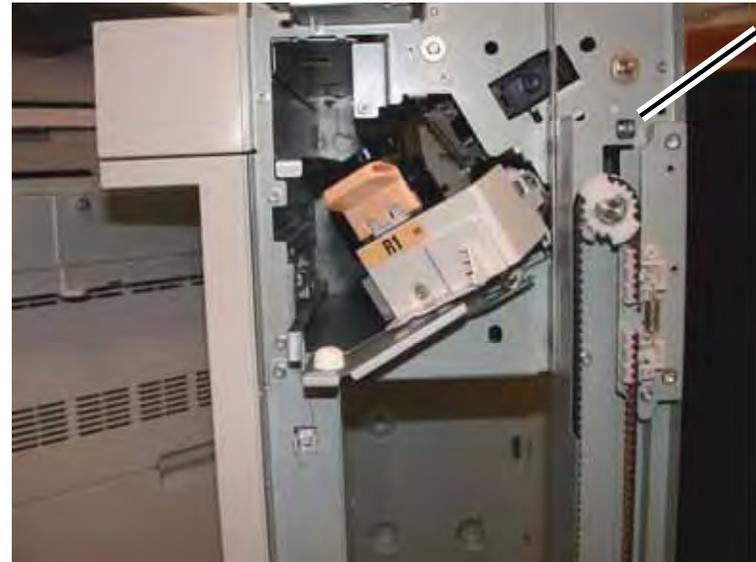
14. Remove the front E-ring and the bushing from the Set Clamp Shaft Assembly (Figure 5).

Figure 5 Removing the front E-ring from the Set Clamp Shaft

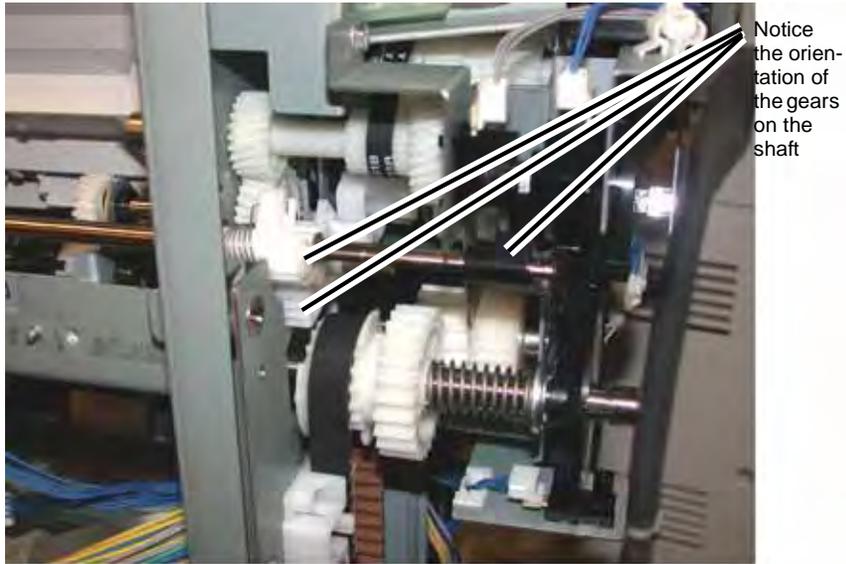
NOTE: Notice the position and orientation of the Set Clamp Shaft gear and the cam gear that it engages. When installing the Set Clamp Shaft these gears must engage in the same manner (Figure 6).

Notice the orientation of the gears on the shaft

Figure 6 Set Clamp Shaft gear orientation

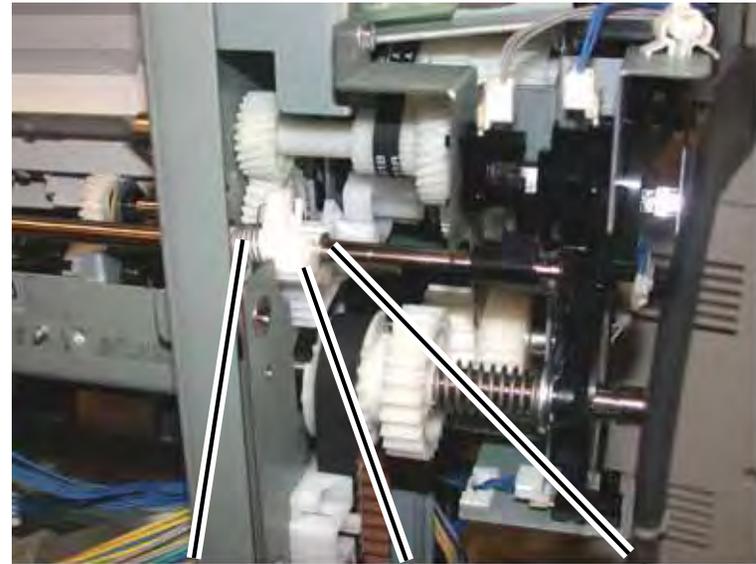
15. Remove the rear E-ring from the Set Clamp Shaft (Figure 7).

3 Disconnect the Spring from the Gear
 2 Slide the Gear away from the frame
 1 Remove the E-ring from the frame

Figure 7 Preparing to remove the Set Clamp Shaft

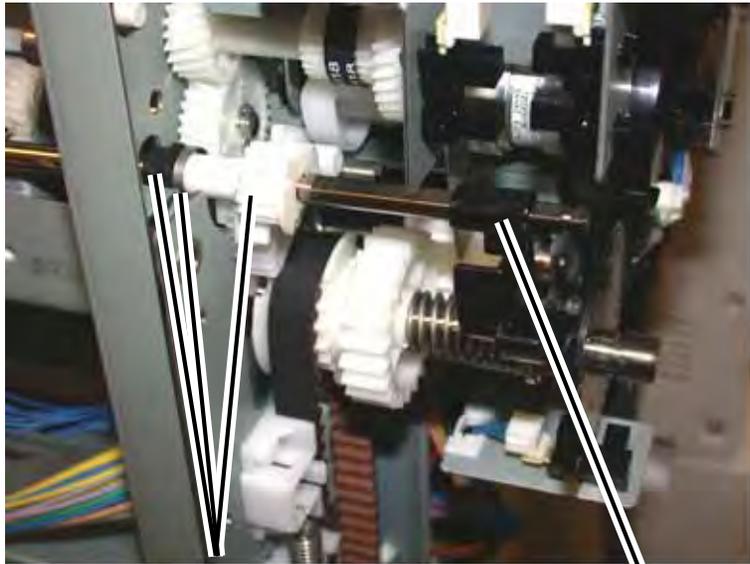
16. Slide the Gear, Spring and the Bushing away from the frame (Figure 8).

2 Slide the Gear, Spring and Bushing toward the end of the Shaft
1 Unlock and remove the Flag

Figure 8 Preparing to remove the Set Clamp Shaft

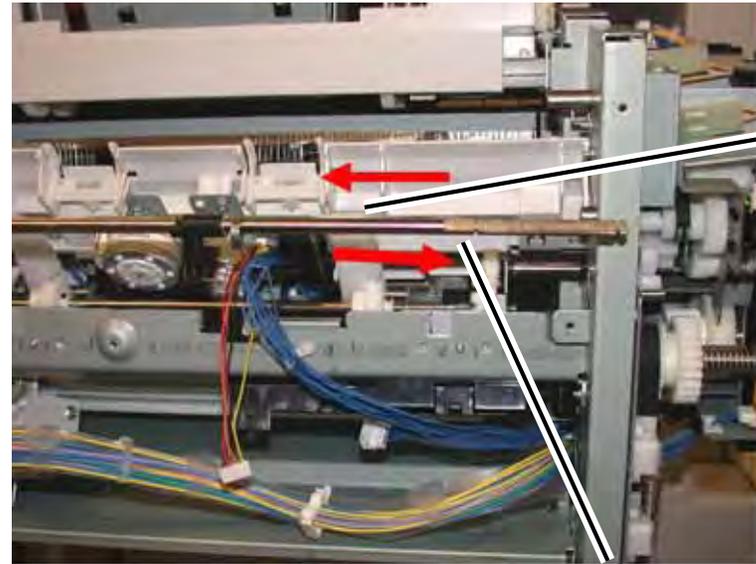
1 Slide the Shaft toward the front
2 Slide the Shaft toward the rear and remove

Figure 9 Removing the Set Clamp Shaft

17. Slide the Set Clamp Shaft to the front to clear the rear frame then slide the Shaft to the rear and remove it from the Finisher (Figure 9).

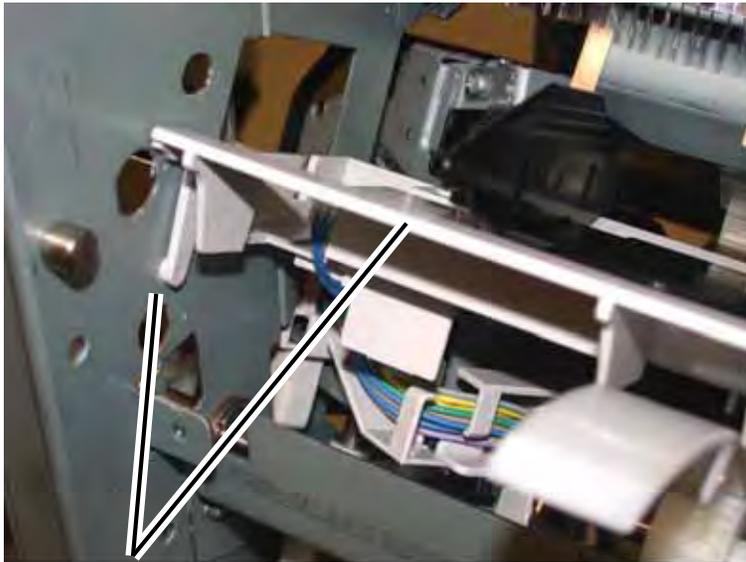
18. Remove the Compiler Tray Assembly (Figure 10).

Remove the Compiler Tray Assembly

Figure 10 Remove the Compiler Tray Assembly

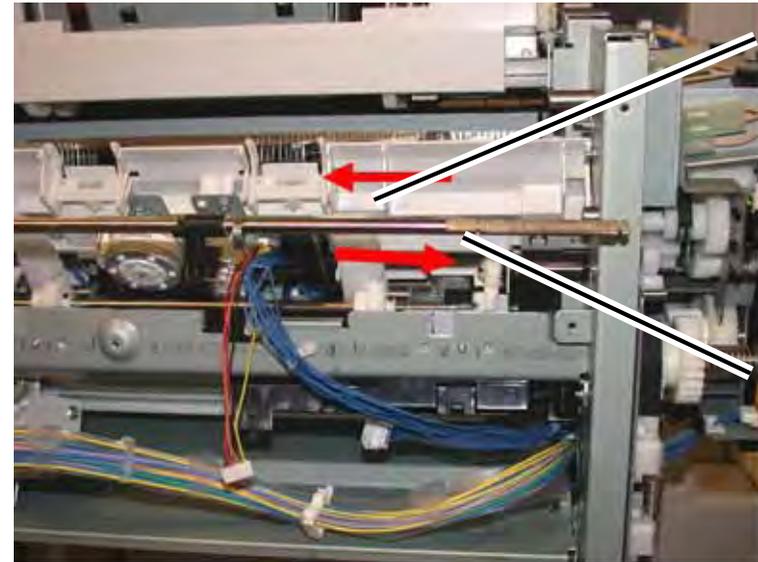
1. Route the wire harness through the wire guides and connect the proper connectors to the No Paper Sensor, the Tamper Home Sensors and the Tamper Motors.
2. Place the Compiler Tray Assembly into position.
3. Install the Set Clamp Shaft front end into the front frame (Figure 11).
4. Slide the Shaft toward the front until the rear end of the Shaft can be inserted into the rear frame (Figure 11).

1
Insert
the front
end of
the shaft
into the
front
frame

2
Insert
the rear
end of
the Shaft
into the
rear
frame

Figure 11 Installing the Set Clamp Shaft into position

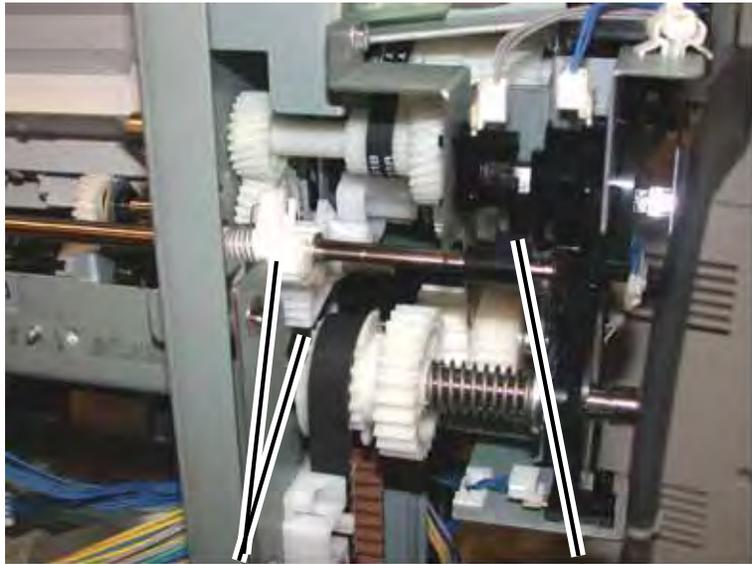
2
Position the 2 Gears

1
Rotate shaft until Stack
Height Flag is in position

Figure 14 Aligning the Gears and Stack Height Sensor Flag

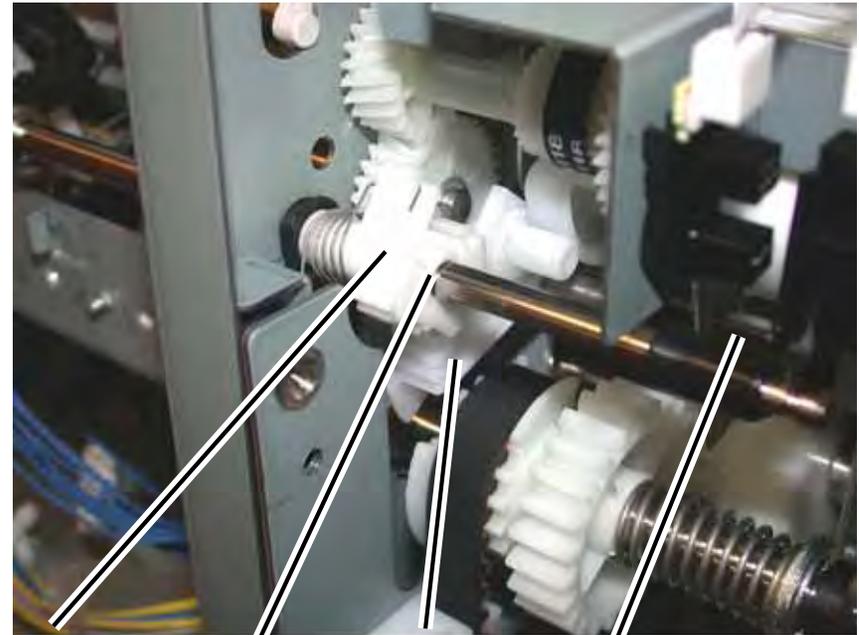
8. Attach the Spring to the gear and slide the Gear into position.
9. Ensure that the 2 Gears and Stack Height Sensor Flag is in the position shown (Figure 15) and install the E-ring.

Shaft Gear
position on Pin-
ion Gear

Install the E-
ring

Figure 15 Orientation of 2 Gears and Stack Height Sensor Flag

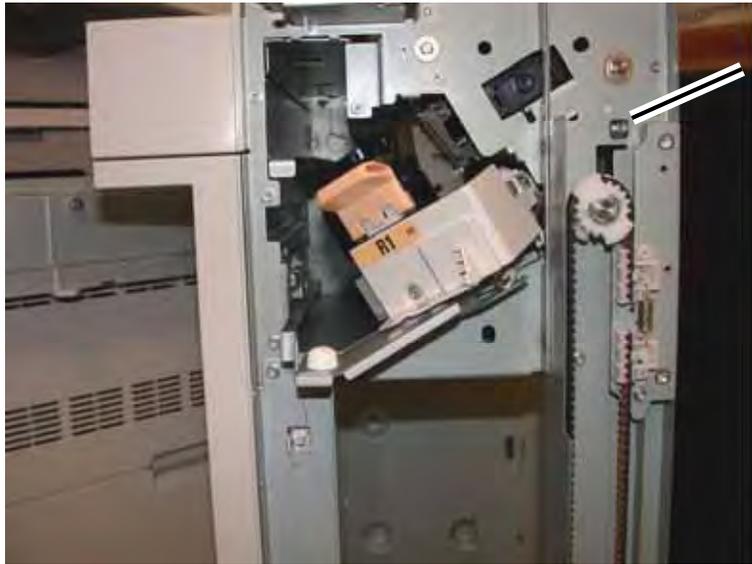
10. Install the Bushing onto the front end of the Set Clamp Shaft and install the E-ring (Figure 16).

Install
the
Bush-
ing and
the E-
ring

Figure 16 Installing the Bushing and E-ring

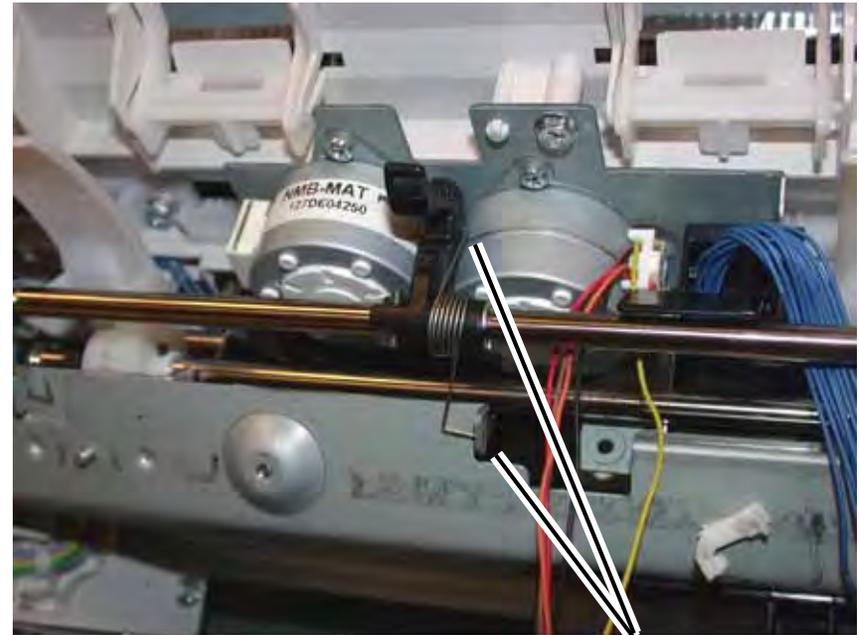
11. Ensure that the Set Clamp Holder Springs are connected (Figure 17).

Spring attaches in 2
spots

Figure 17 Attaching the Set Clamp Holder Springs

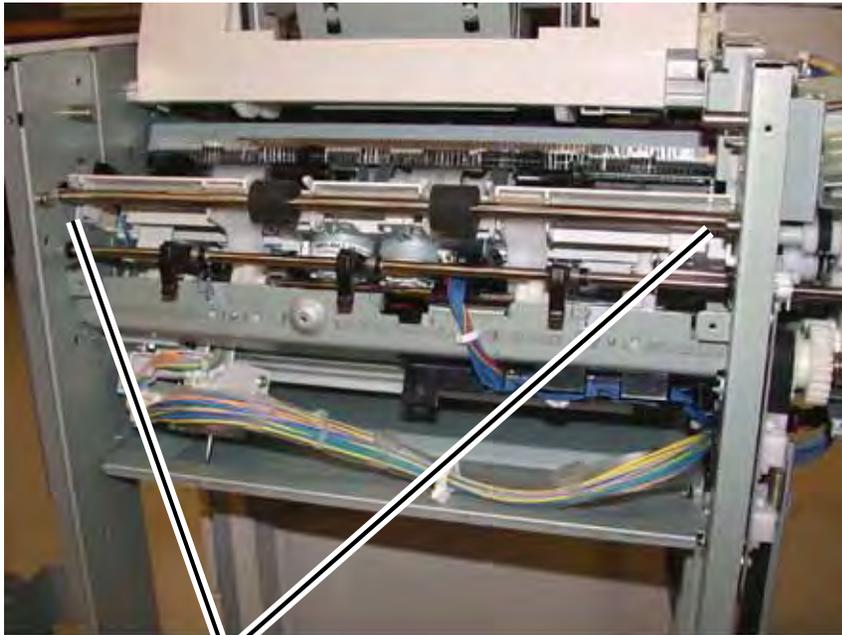
12. Install the Eject Roll Shaft.
 - (1) Place the Eject Roll Shaft into position in the front and rear frame (Figure 18).

Eject Roll Shaft in position

Figure 18 Preparing to install the Eject Roll Shaft

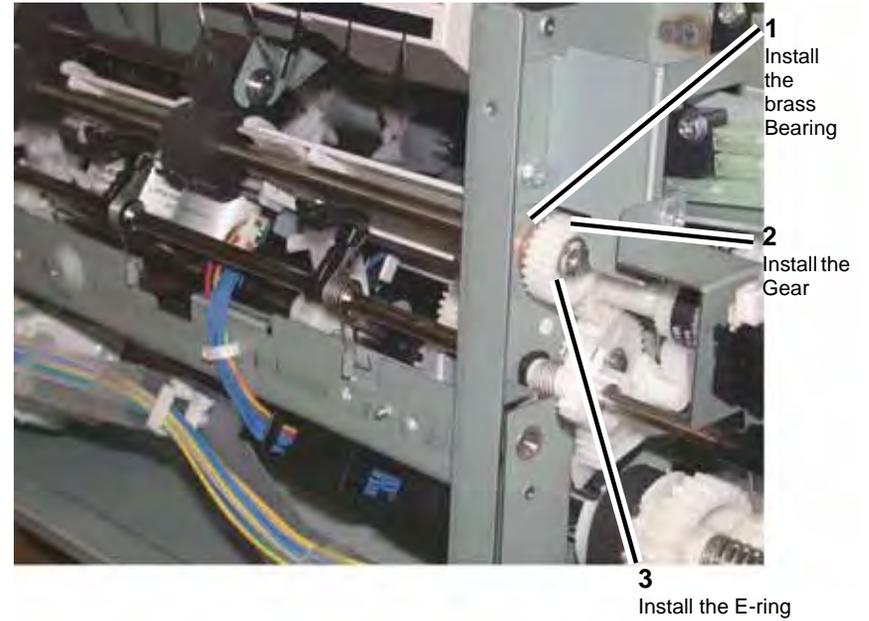
(2) Install the brass bearing, the Gear and the E-ring onto the rear of the Eject Roll Shaft (Figure 19).

Figure 19 Installing the Eject Roll Shaft rear parts

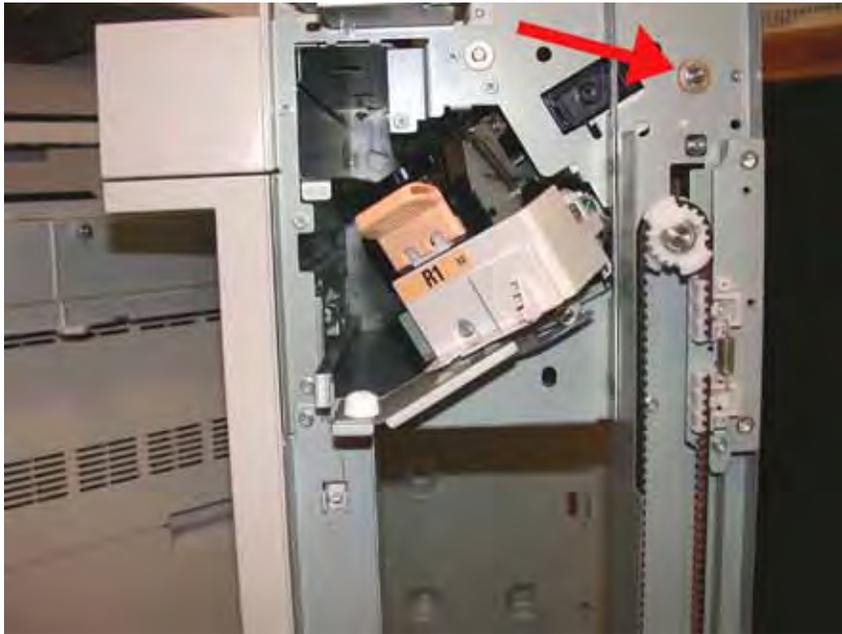
(3) Install the brass bearing and E-ring onto the front of the Eject Roll Shaft (Figure 20).

Figure 20 Installing the brass bearing and E-ring

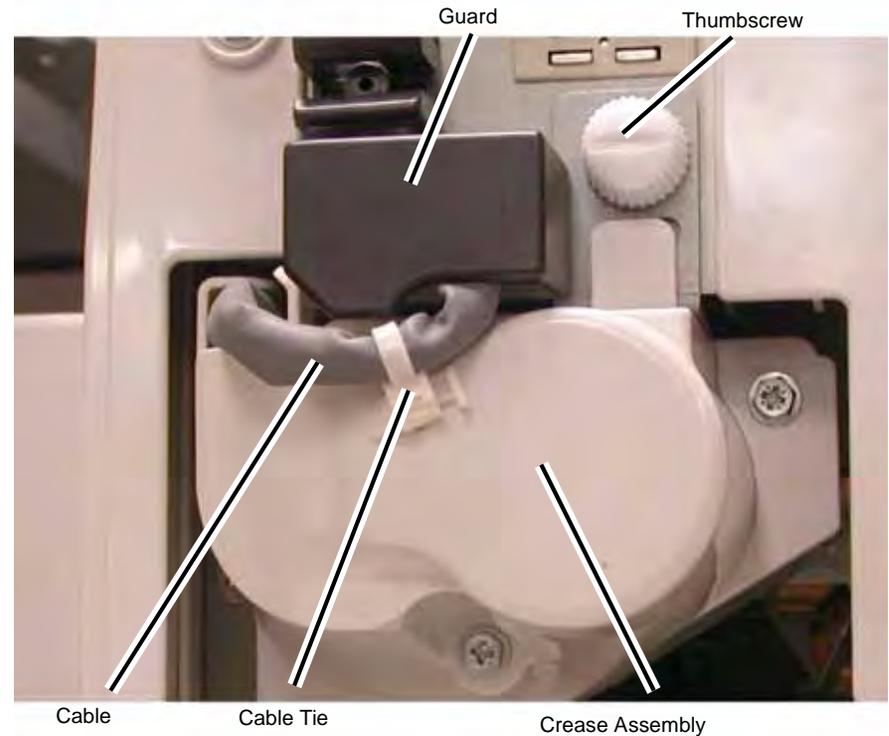
- (3) Disconnect the Cable.
- (4) Remove the Thumbscrew.
- (5) Pull the Crease Assembly straight out.

Figure 1 Removing the Crease Assembly

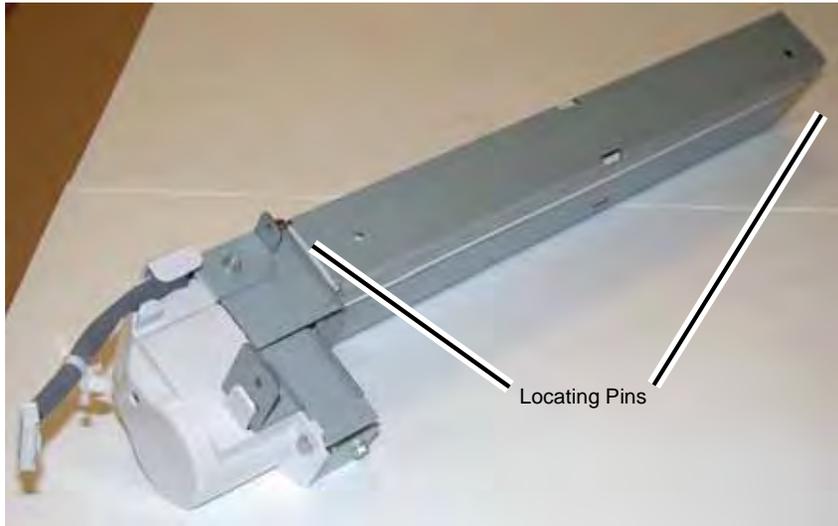
NOTE: Make sure the Locating Pins (2) are properly engaged (Figure 2).

Figure 2 Crease Assembly

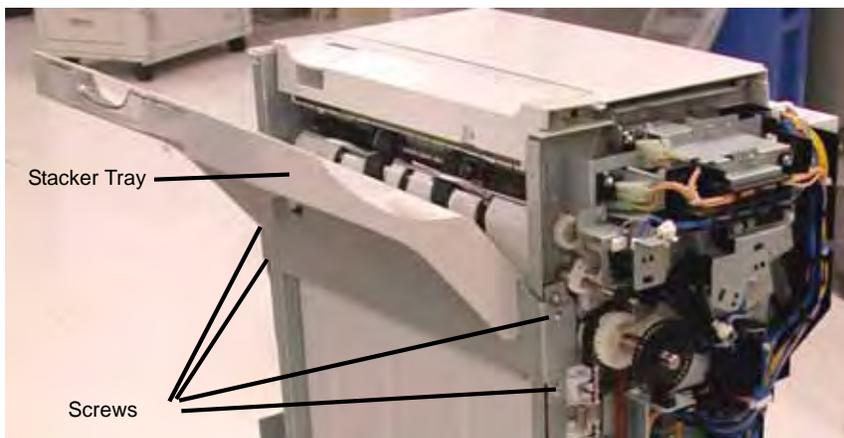
1. Switch off the power and disconnect the power cord.
2. Remove the following:
 - (1) Booklet Maker Assembly (if installed) ([REP 13.31](#)).
 - (2) Front Cover Assembly ([REP 13.6](#)).
 - (3) Rear Upper Cover ([REP 13.7](#)).
3. Remove the Stacker Tray ([Figure 1](#)).
 - (1) Remove the Screws (4).
 - (2) Remove the Stacker Tray.

Figure 1 Removing the Stacker Tray

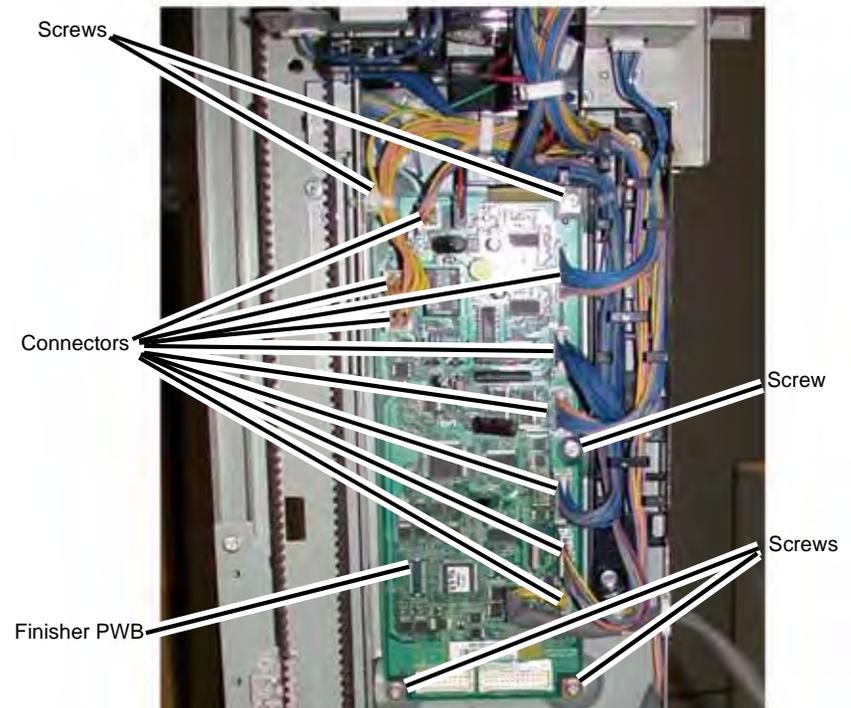
1. Switch off the power and disconnect the power cord.
2. Remove the Rear Upper Cover ([REP 13.7](#)).
3. Remove the Finisher PWB ([Figure 1](#)).
 - (1) Disconnect the Connectors (9).
 - (2) Remove the Screws (5).
 - (3) Remove the Finisher PWB.

Figure 1 Removing the Finisher PWB

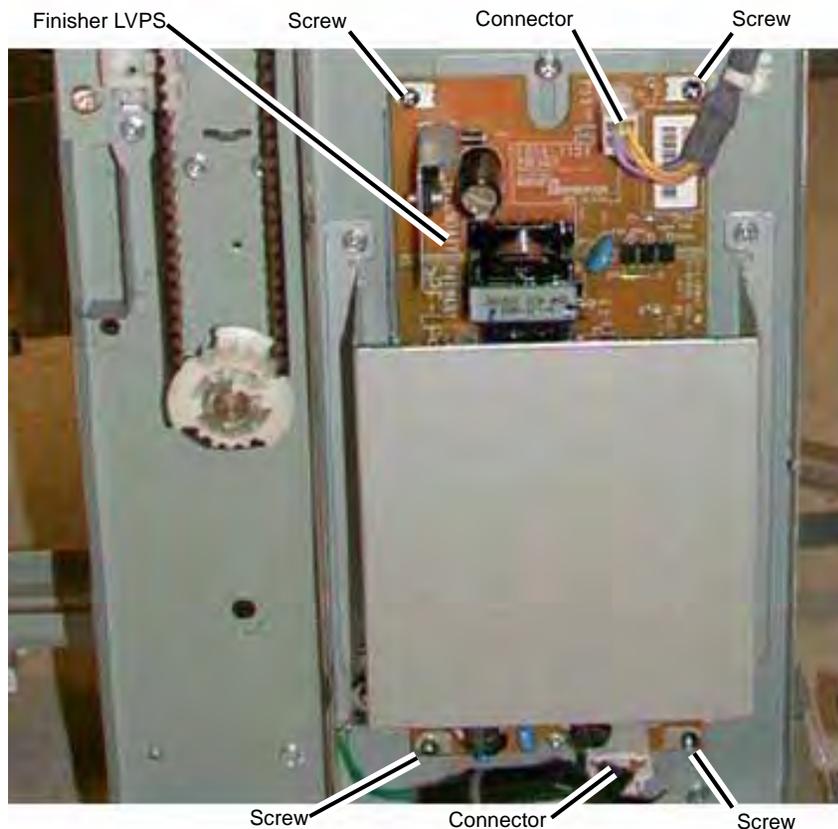
1. Switch off the power and disconnect the power cord.
2. Remove the Rear Lower Cover ([REP 13.8](#)).
3. Remove the Finisher LVPS ([Figure 1](#)).
 - (1) Disconnect the Connectors (2).
 - (2) Remove the Screws (4).
 - (3) Remove the Finisher LVPS.

Figure 1 Removing the Finisher LVPS

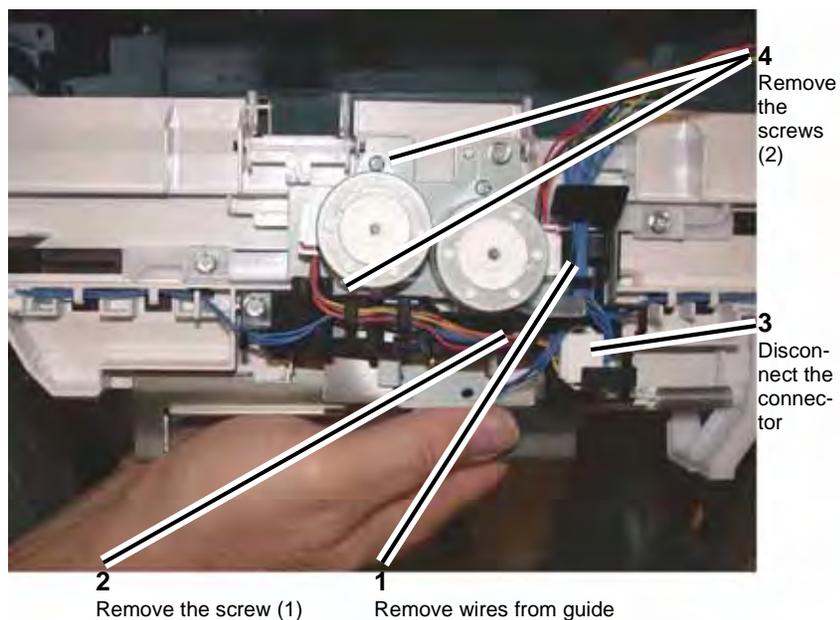
- (4) Remove the screws (2).
- (5) Remove the Tamper Motor.

Figure 1 Removing the Tamper Motor

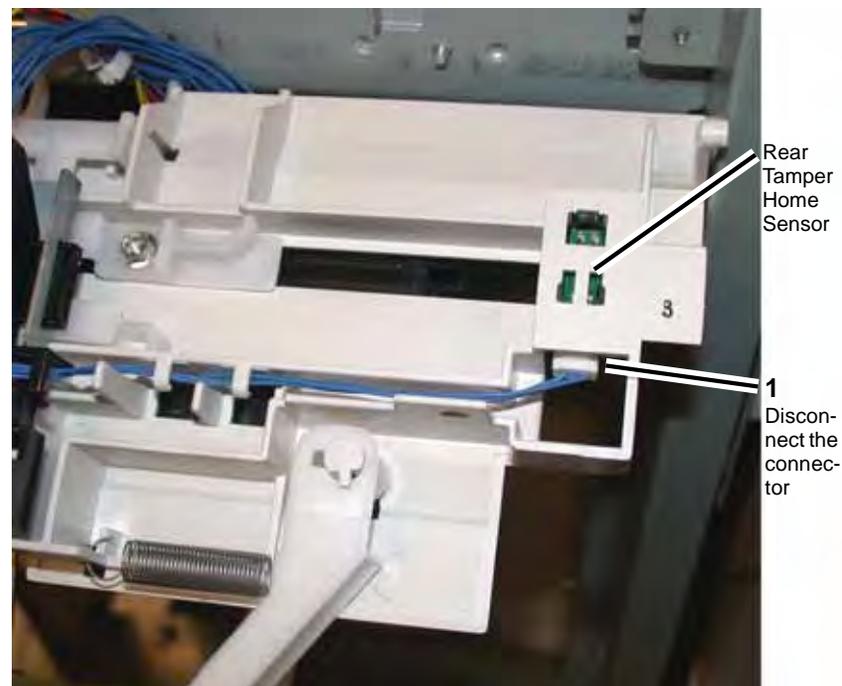
1. Switch off the power and disconnect the power cord.
2. Remove the Compiler Tray Assembly ([REP 13.17](#)).
3. Turn the Compiler Tray over on a work surface ([Figure 1](#)).
4. Disconnect the connector.
5. Remove the Front or Rear Tamper Home Sensor ([PL 23.12](#)).

Figure 1 Removing the Front or Rear Tamper Home Sensor

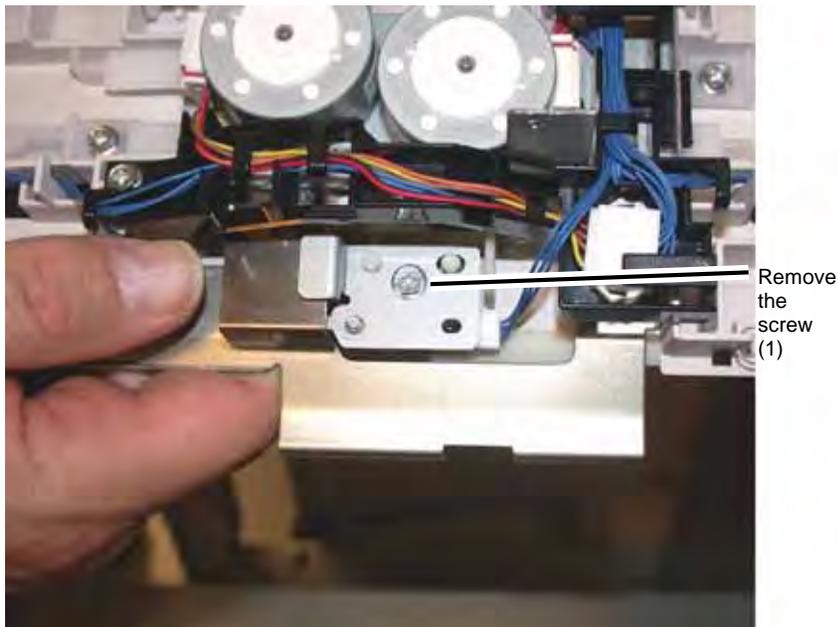
1. Switch off the power and disconnect the power cord.
2. Remove the Compiler Tray Assembly ([REP 13.17](#)).
3. Turn the Compiler tray over on a work surface.
4. Remove the screw (1) that secures the bracket ([PL 23.12](#)) ([Figure 1](#)).

Figure 1 Removing the Bracket

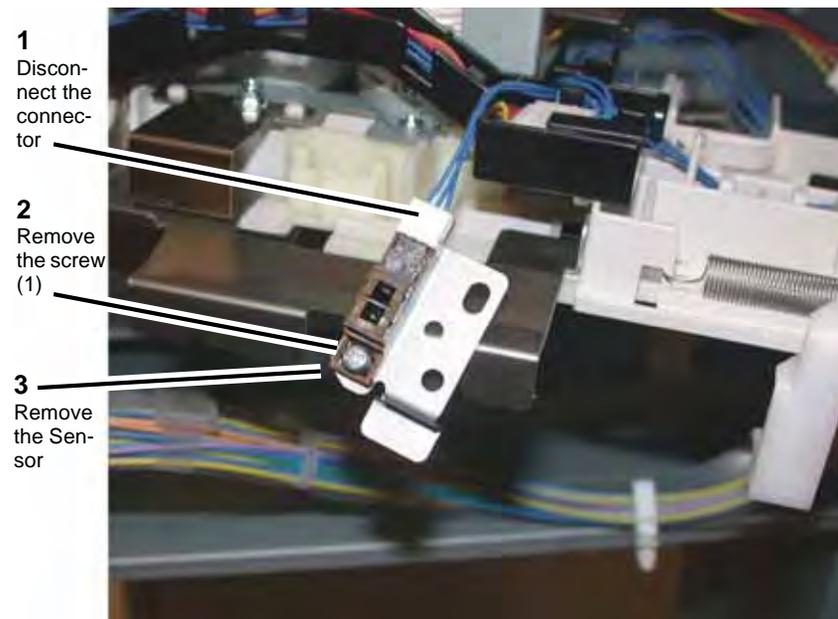
5. Disconnect the connector ([Figure 2](#)).
6. Remove the screw (1) that secures the sensor.
7. Remove the Compiler No Paper Sensor.

Figure 2 Removing the Compiler No Paper Sensor

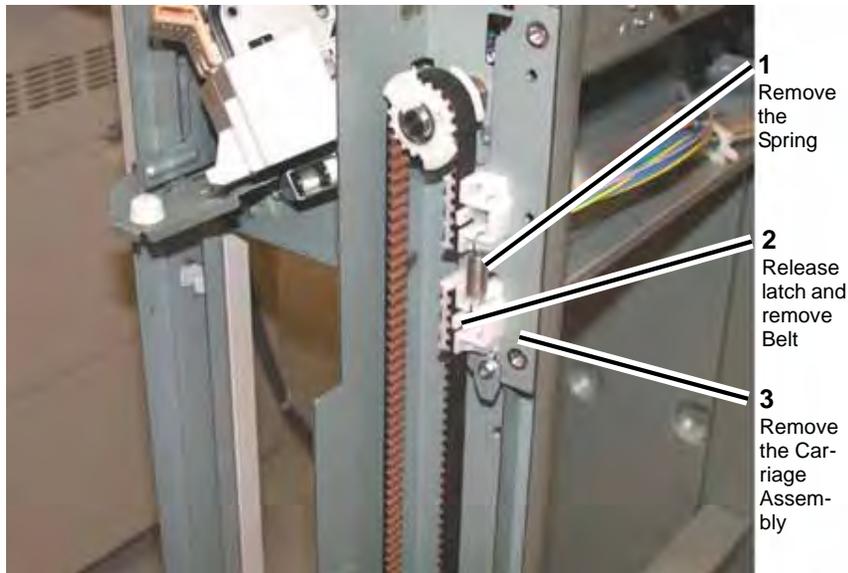
NOTE: The Carriage Bearings (2 each Assembly) are not fastened to the shafts. Use care to catch the Bearings when the Carriage Assembly is removed.

- (2) With a 6 inch common screwdriver, move the belt Clamp latch aside and remove the Stacker Belt and Carriage Assembly.

Figure 1 Removing the Carriage Assembly

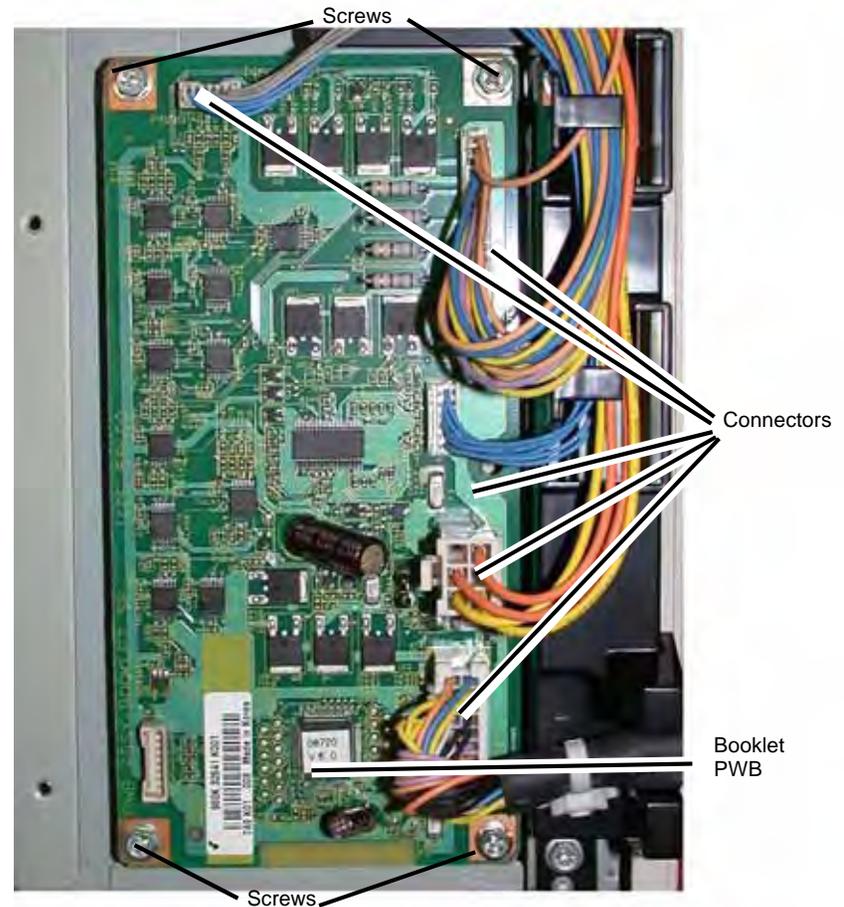
1. Switch off the power and disconnect the power cord.
2. Remove the Booklet PWB Cover ([REP 13.35](#)).
3. Remove the Booklet PWB ([Figure 1](#)).
 - (1) Disconnect the Connectors (5).
 - (2) Remove the Screws (4).
 - (3) Remove the Booklet PWB.

Figure 1 Removing the Booklet PWB

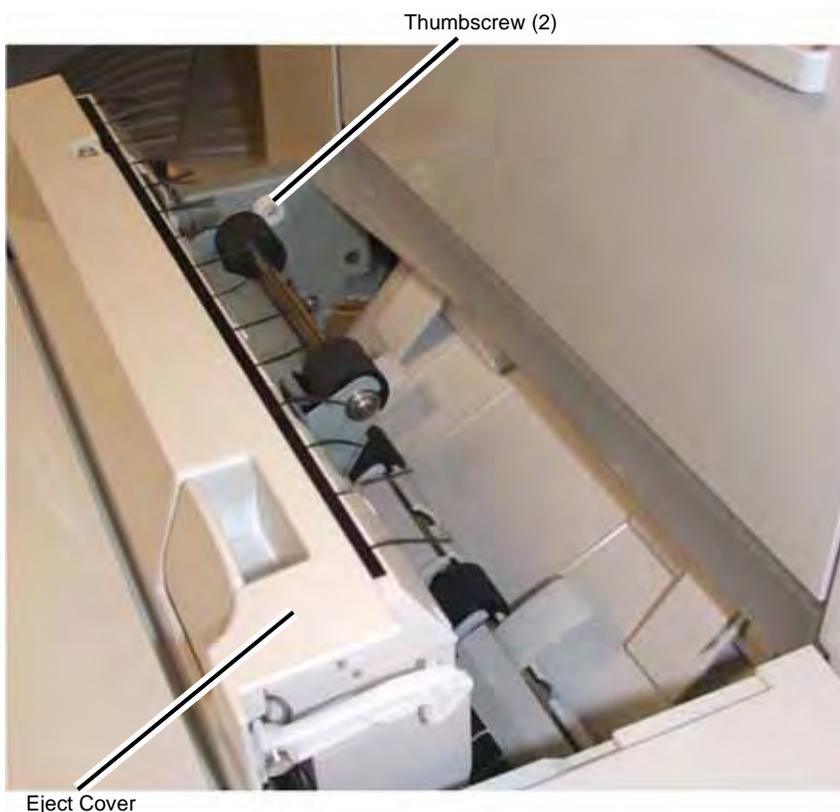
1. Switch off the power and disconnect the power cord.
2. Unlatch the Eject Cover, and move it all the way to the left ([Figure 1](#)).
3. Remove the Thumbscrews (2) ([Figure 1](#)).

Figure 1 Eject Cover and Thumbscrew

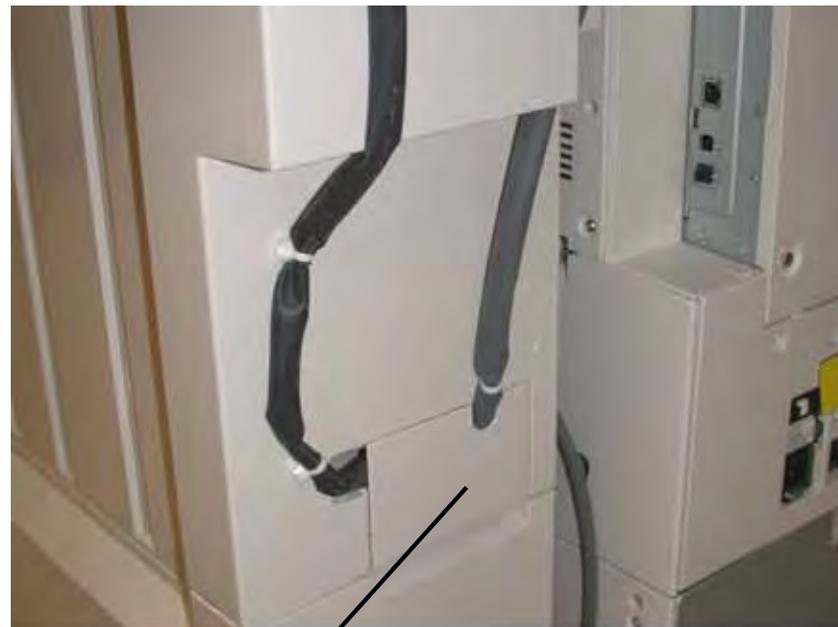
4. Disconnect the Booklet Maker Assembly from the Finisher.
 - (1) Remove the Connector Cover ([Figure 2](#)).

Figure 2 Connector Cover

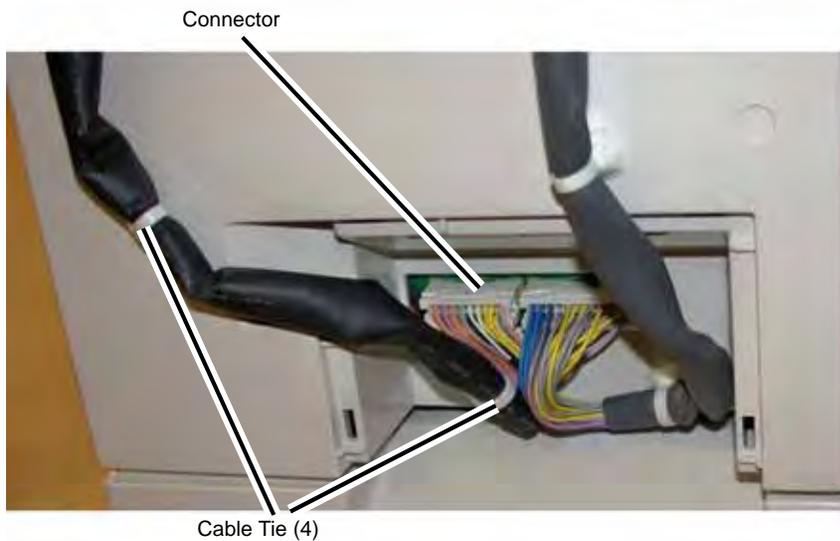
- (2) Disconnect the Connector ([Figure 3](#)).
- (3) Pull out the Cable Ties (4).

Figure 3 Disconnecting the Booklet Maker Assembly

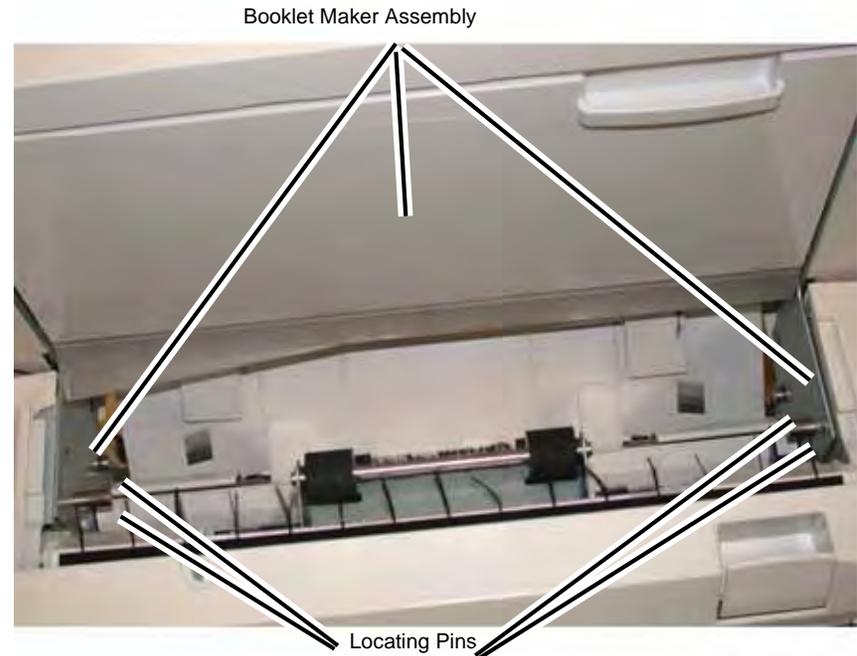
5. Lift the Booklet Maker Assembly off the Locating Pins (4), and remove (Figure 4).

Figure 4 Removing the Booklet Maker Assembly

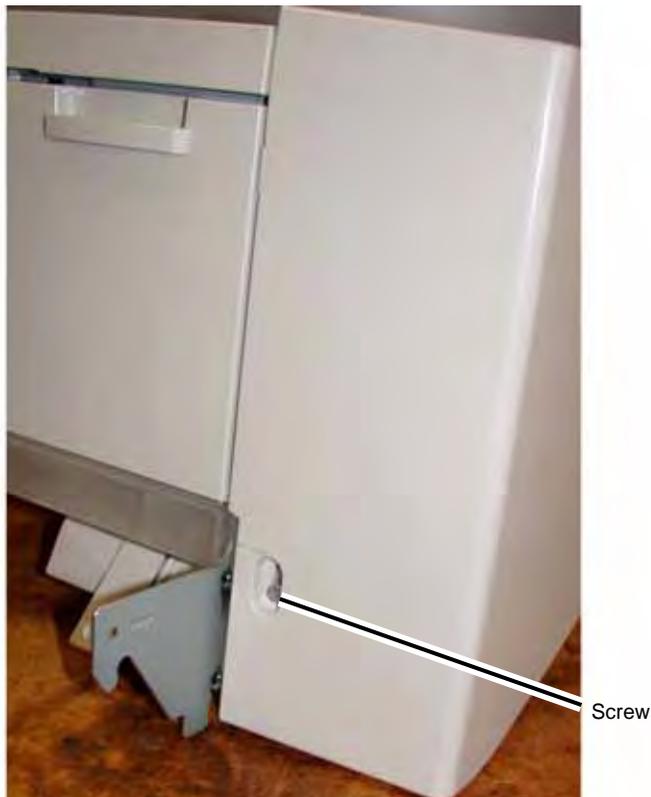
1. Switch off the power and disconnect the power cord.
2. Remove the Booklet Maker Assembly from the Finisher ([REP 13.31](#)).
3. Remove the Booklet Front Cover.
 - (1) Remove the Screw (1) ([Figure 1](#)).

Figure 1 Removing the Booklet Front Cover
