WorkCentre 5335 Family Service Documentation

705P01303

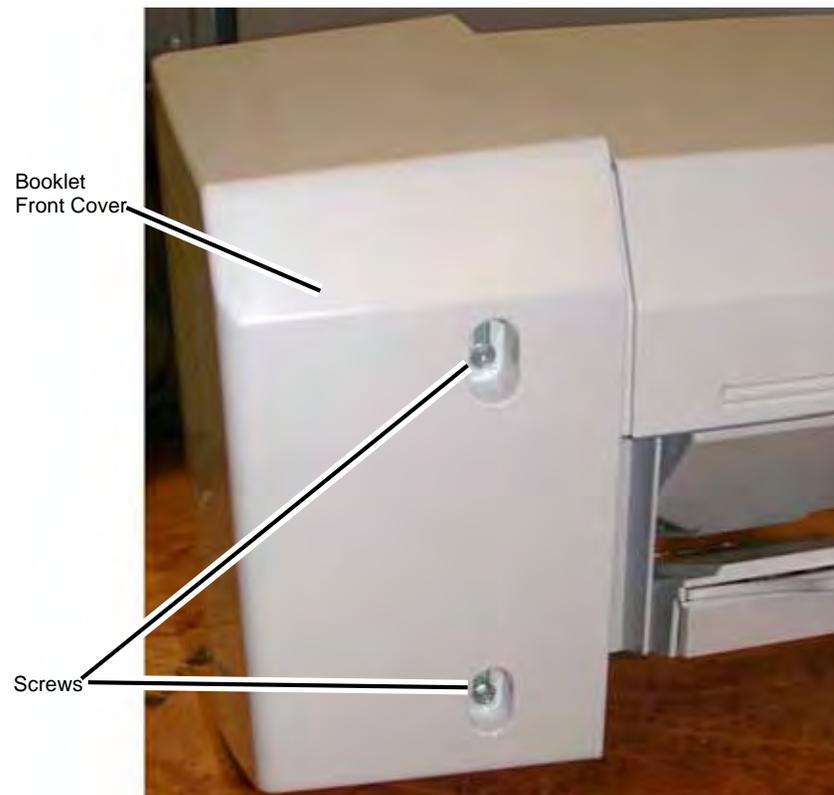
- (2) Remove the Screws (2) ([Figure 2](#)).
- (3) Remove the Booklet Front Cover.

Figure 2 Removing the Booklet Front Cover

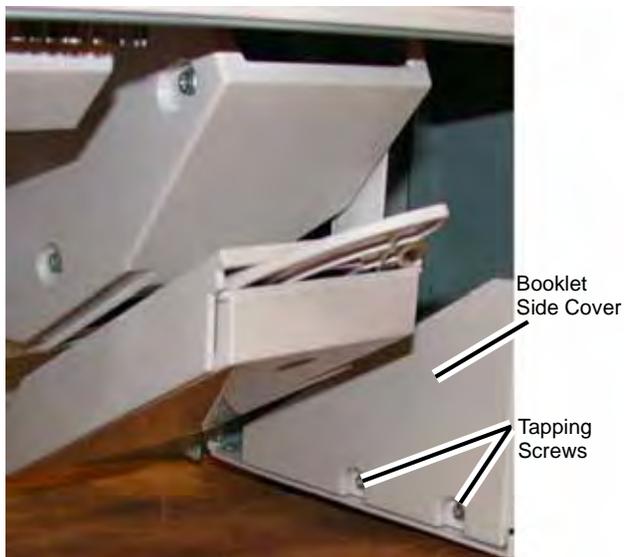
1. Switch off the power and disconnect the power cord.
2. Remove the Booklet Maker Assembly from the Finisher ([REP 13.31](#)).
3. Remove the Booklet PWB Cover ([REP 13.35](#)).
4. Remove the Booklet Rear Cover.
 - (1) Remove the Self-tapping Screws (2) ([Figure 1](#)).
 - (2) Remove the Booklet Side Cover.

Figure 1 Removing the Booklet Side Cover

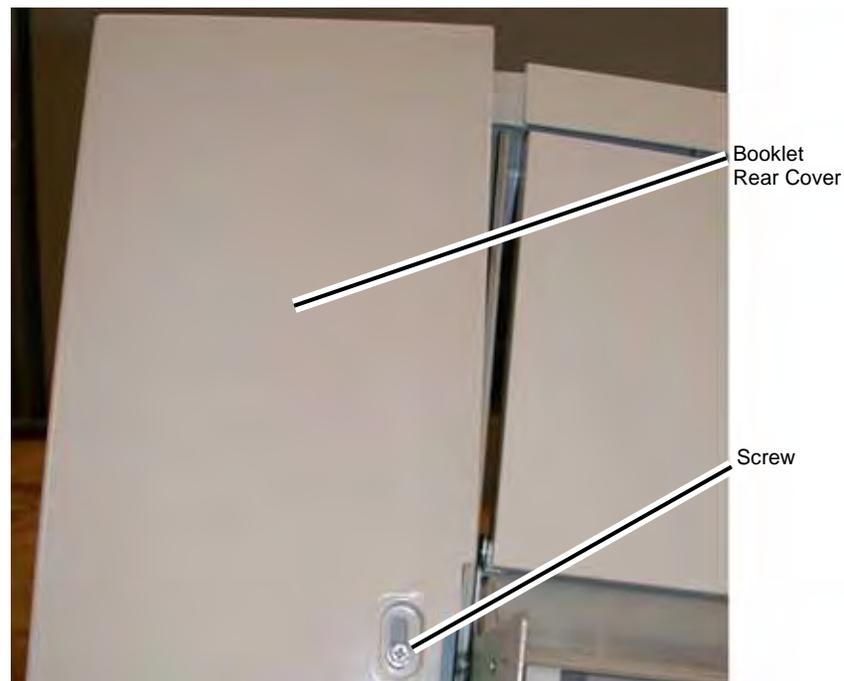
- (3) Remove the Screw (1) ([Figure 2](#)).
- (4) Remove the Booklet Rear Cover.

Figure 2 Removing the Booklet Rear Cover

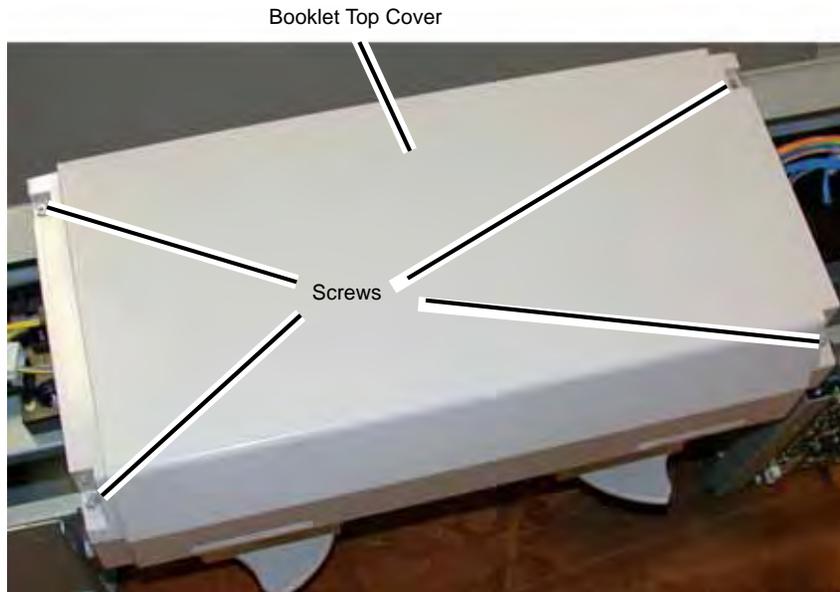
1. Switch off the power and disconnect the power cord.
2. Remove the Booklet Front Cover ([REP 13.32](#)).
3. Remove the Booklet Rear Cover ([REP 13.33](#)).
4. Remove the Booklet Top Cover ([Figure 1](#)).
 - (1) Remove the Screws (4).
 - (2) Remove the Booklet Top Cover.

Figure 1 Removing the Booklet Top Cover

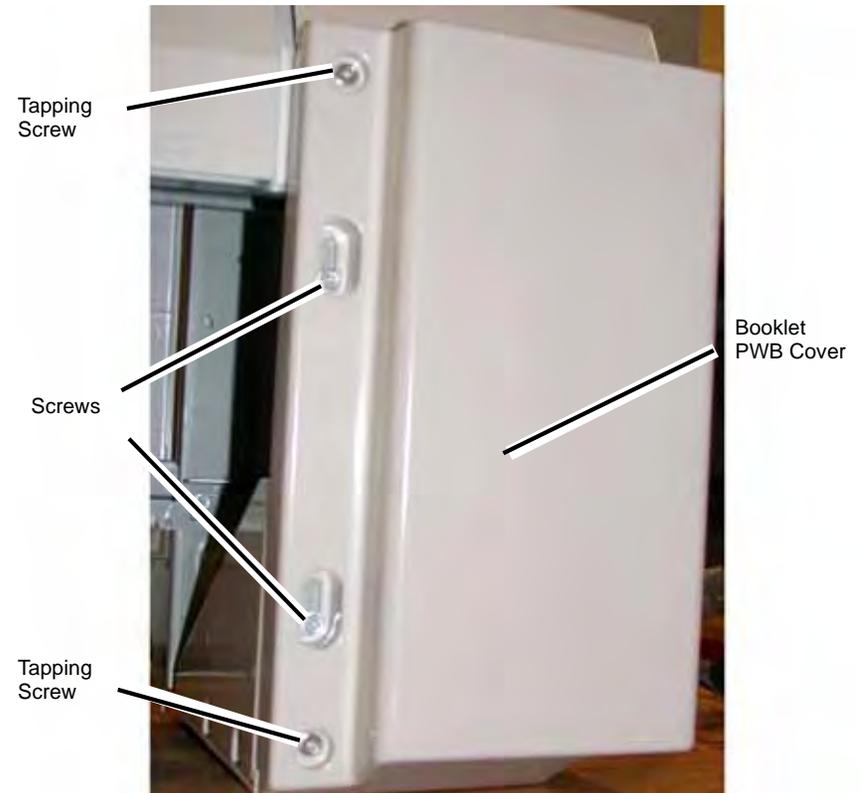
Figure 1 Removing the Booklet PWB Cover

1. Switch off the power and disconnect the power cord.
2. Remove the Booklet PWB Cover ([Figure 1](#)).
 - (1) Remove the Self-tapping Screws (2).
 - (2) Remove the Screws (2).
 - (3) Remove the Booklet PWB Cover.

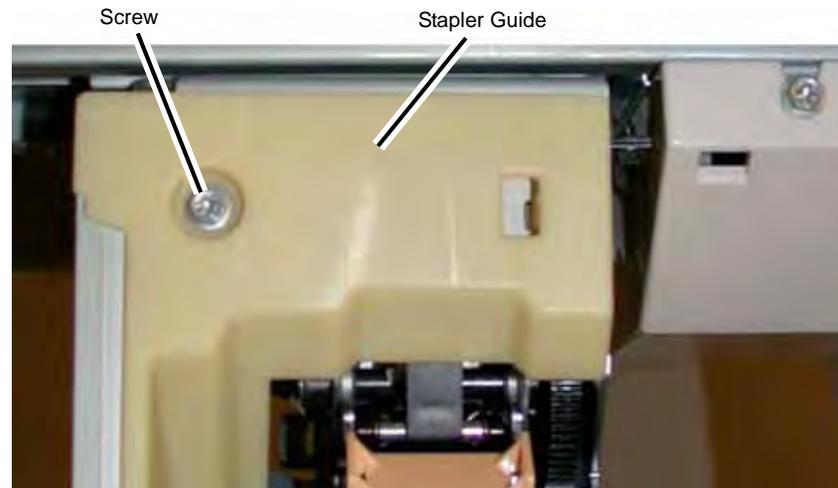
Figure 1 Removing the Stapler Guide

1. Switch off the power and disconnect the power cord.
2. Remove the Booklet Maker Assembly from the Finisher ([REP 13.31](#)).
3. Remove the Stapler Guide ([Figure 1](#)).
 - (1) Remove the Screw (1).
 - (2) Remove the Stapler Guide.

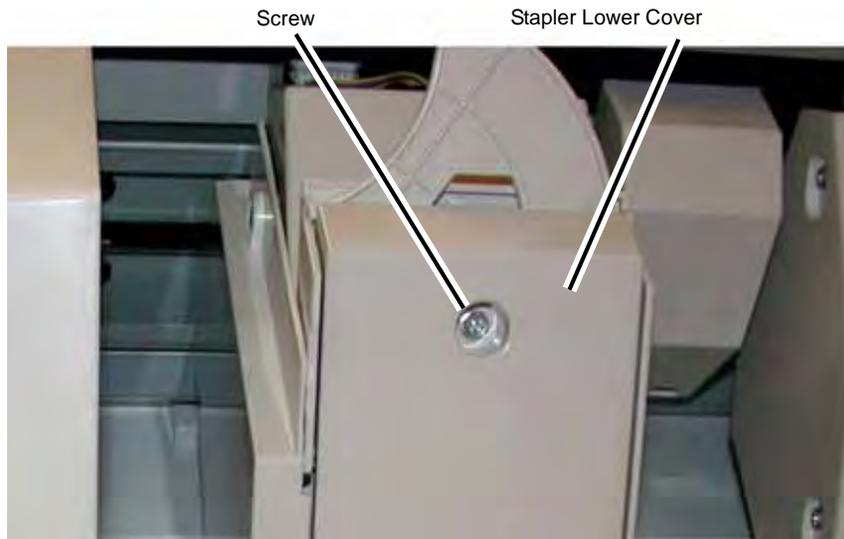
Figure 2 Removing the Stapler Lower Cover

4. Remove the Stapler Lower Cover ([Figure 2](#)).
 - (1) Remove the Screw (1).
 - (2) Remove the Stapler Lower Cover.

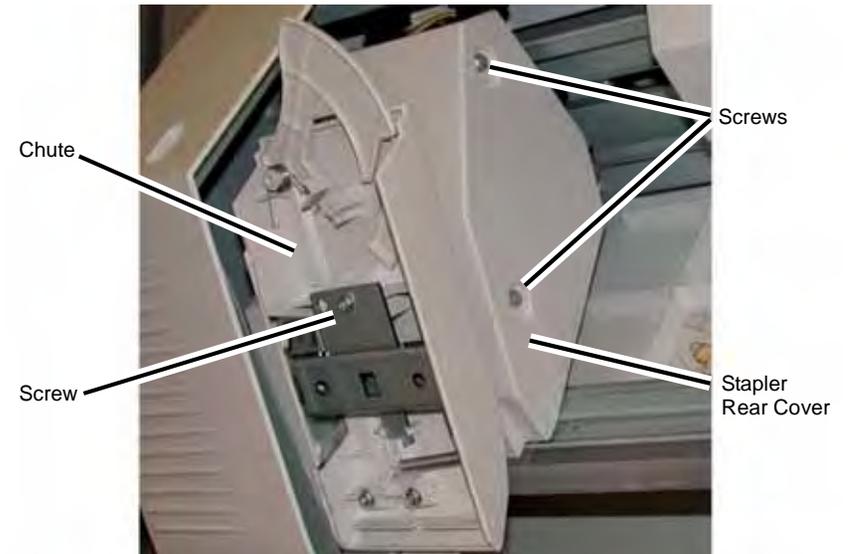
Figure 3 Removing the Chute and Stapler Rear Cover

5. Remove the Chute (Figure 3).
 - (1) Remove the Screw (1).
 - (2) Remove the Chute.
6. Remove the Stapler Rear Cover (Figure 3).
 - (1) Remove the Screws (2).
 - (2) Remove the Stapler Rear Cover.
7. Remove the Stapler (Figure 4).
 - (1) Release the wires from the Clip.
 - (2) Disconnect the Connector.
 - (3) Remove the Screws (3).
 - (4) Remove the Stapler.

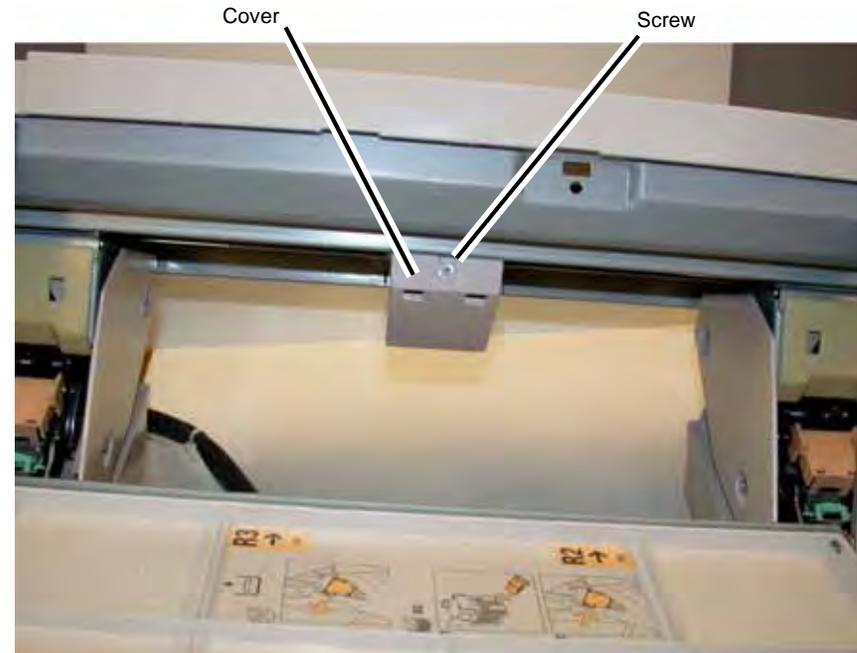
Figure 1 Removing the Cover

1. Switch off the power and disconnect the power cord.
2. Remove the Booklet Maker Assembly from the Finisher ([REP 13.31](#)).
3. Remove the Cover for the Booklet Stapler Move Motor ([Figure 1](#)).
 - (1) Remove the Screw (1).
 - (2) Remove the Cover.

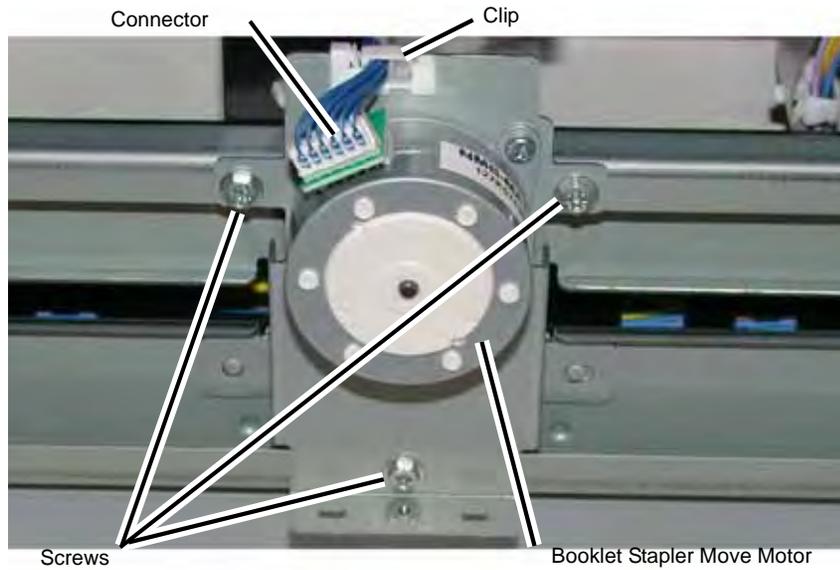
Figure 2 Removing the Booklet Stapler Move Motor

4. Remove the Booklet Stapler Move Motor ([Figure 2](#)).
 - (1) Open the Clip and release the wires.
 - (2) Disconnect the Connector.
 - (3) Remove the Screws (3).
 - (4) Remove the Booklet Stapler Move Motor.

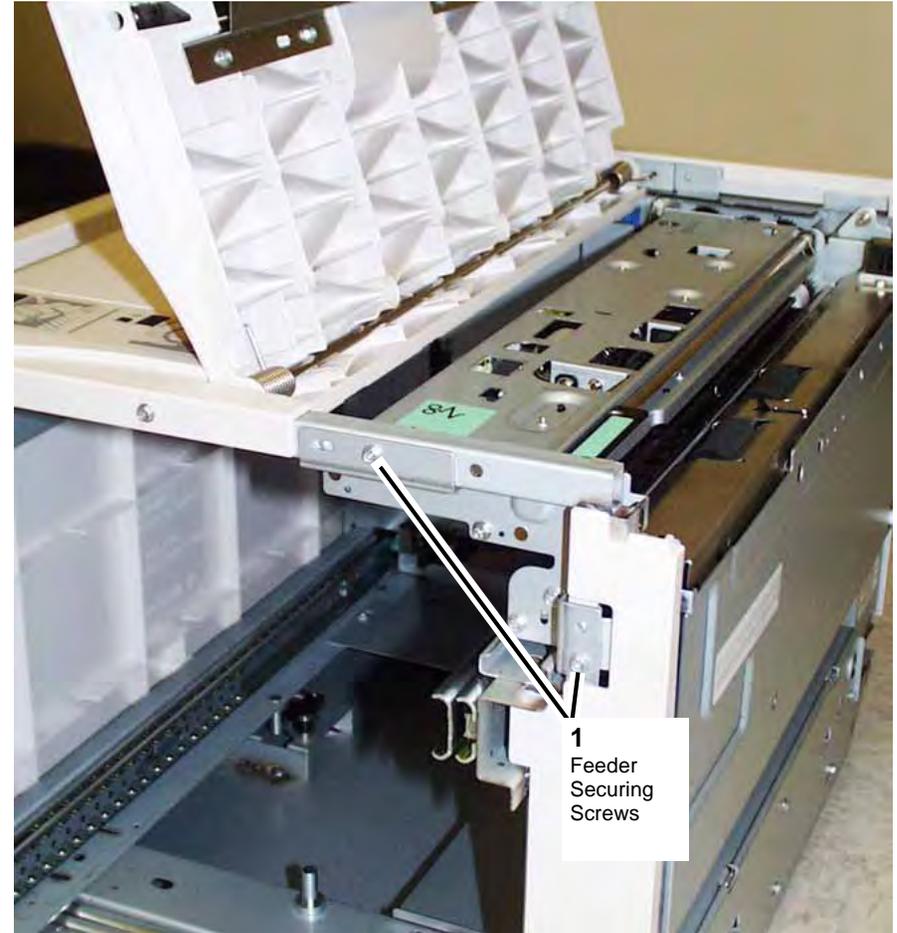
Figure 1 Feeder Securing Screws

1. Switch off the power and disconnect the power cord.
2. Remove the HCF Tray ([REP 19.1](#)).
3. Open the Feeder Top Cover.
4. Remove the (2) screws used to secure the HCF Feeder on its rail ([Figure 1](#)).

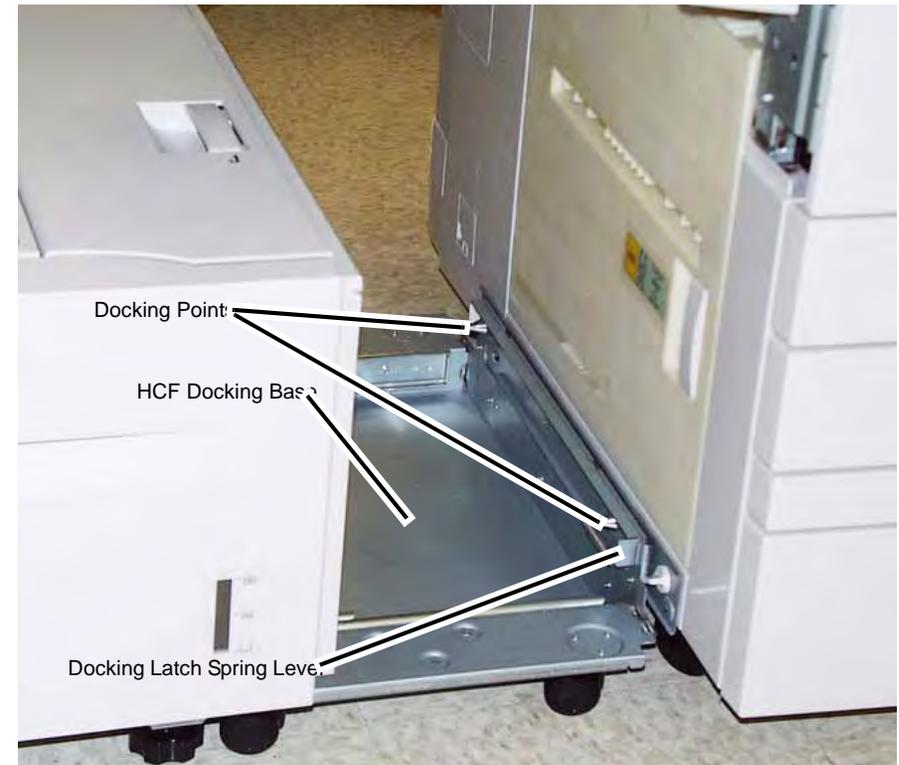
Figure 1 Exposing the docking base

1. Switch off the power and disconnect the power cord.
2. Unplug the HCF Power Cable connected to the left rear of the copier/printer.
3. Grasping the HCF by its upper corners, pull the HCF away from the copier/printer to expose the HCF Docking Base (Figure 1).

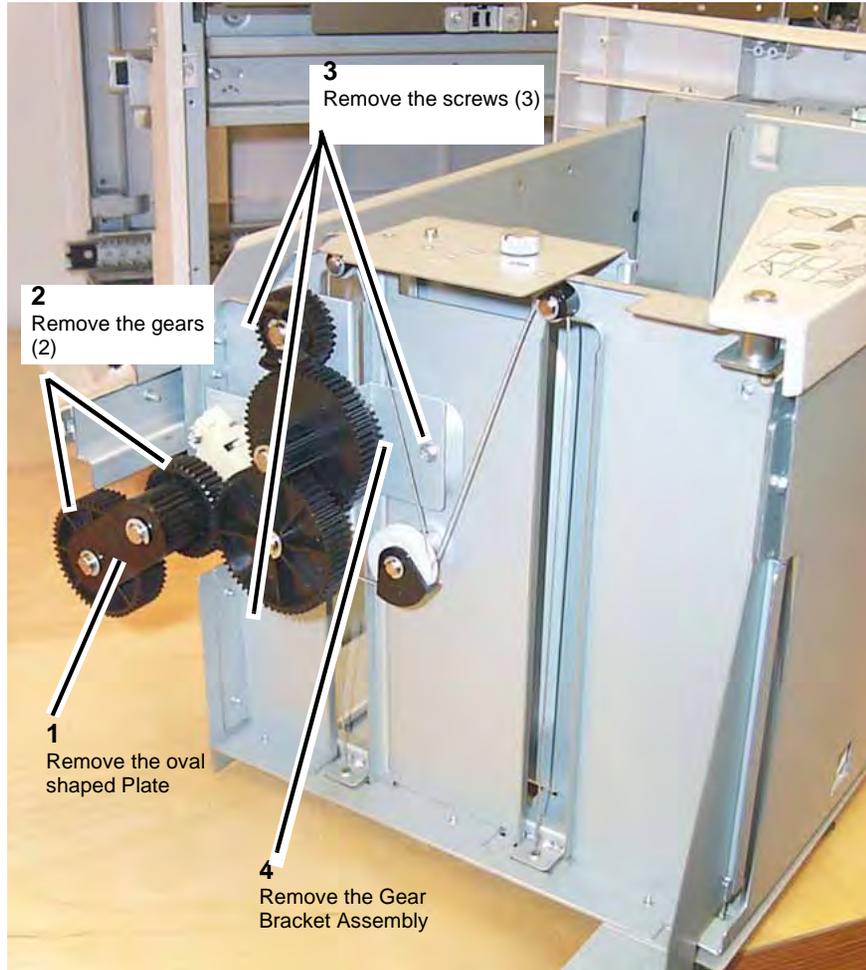
Figure 1 Gear Bracket Assembly

1. Remove the HCF Tray ([REP 19.1](#))
2. Remove the Gear Bracket Assembly ([Figure 1](#)).

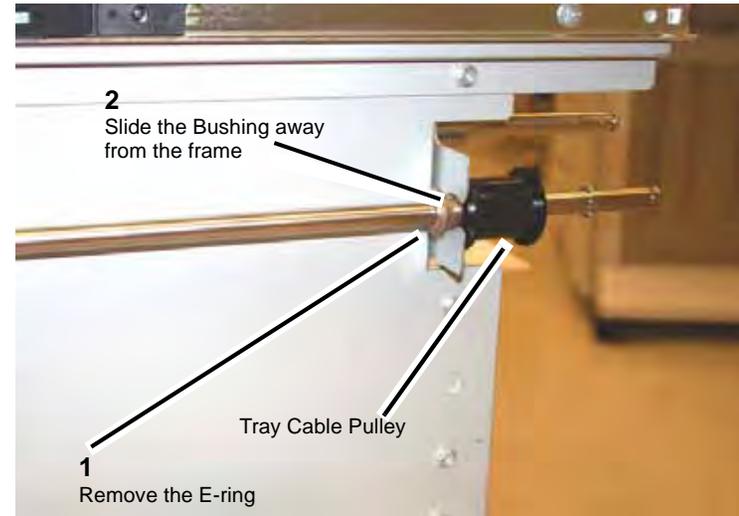
Figure 2 Lift Shaft Rear Tray Cable Pulley

3. At the rear of the HCF Tray, begin to free up movement of the Tray Cable Pulley ([Figure 2](#)).

NOTE: You will not be able to release the cable ends from underneath the Tray Cable Pulley until you perform the next step, which puts slack in the cable enabling the Lift Shaft to be disengaged from its bracket, and the Tray Cable Pulley moved farther to the left releasing the cable ends.

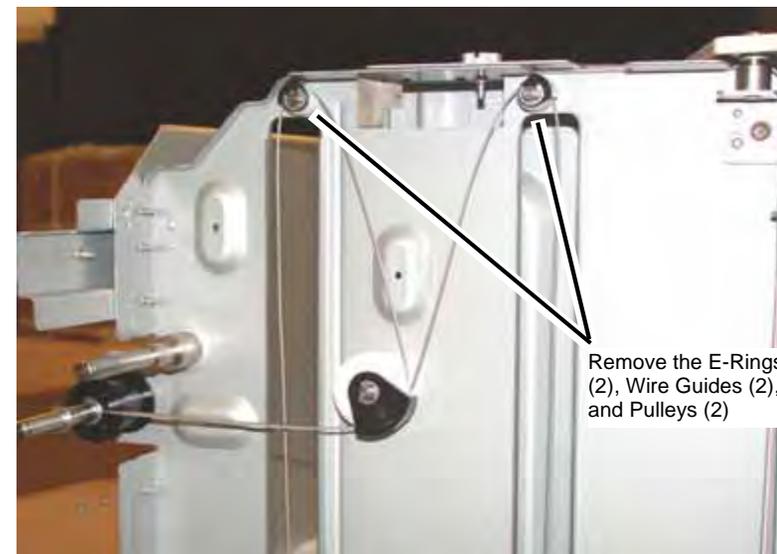
Figure 3 Preparing to remove the Rear Tray Cable

4. Prepare to remove the Rear Tray Cable ([Figure 3](#)).

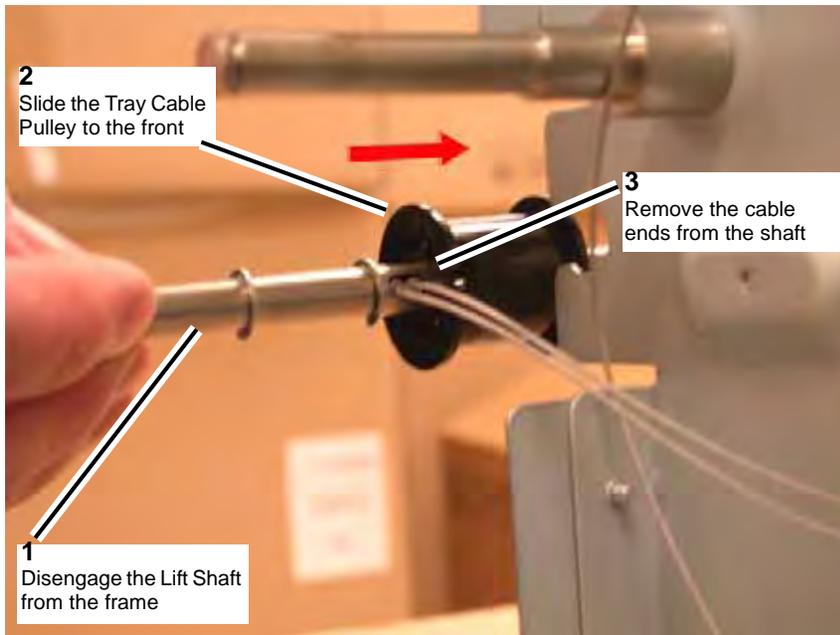
Figure 4 Releasing the Cable ends from the Lift Shaft

- When both sections of the cable are slack, disengage the Lift Shaft from the frame and slide the Tray Cable Pulley to the front of the Lift Shaft to release the Rear Lift Cable ends that are trapped in the pocket underneath the Tray Cable Pulley (Figure 4).

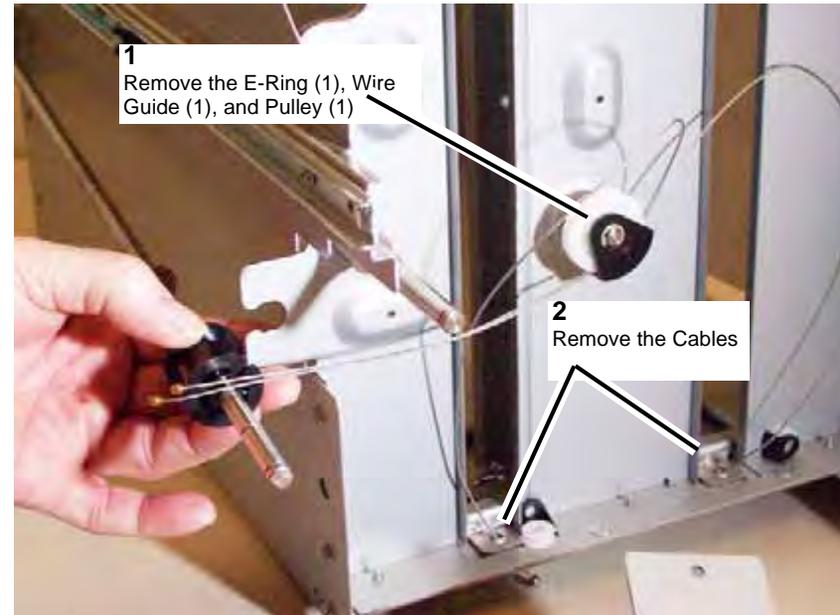
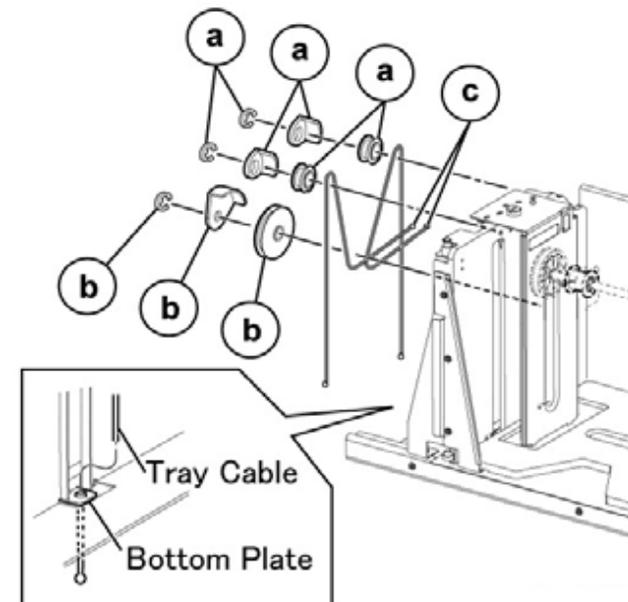
- Remove the Rear Tray Cable (Figure 5, Figure 6).

Figure 5 Removing the Rear Tray Cables

Figure 6 Rear Tray Cable details

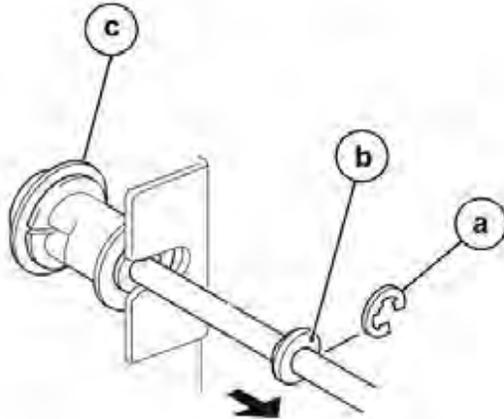
Figure 7 Lift Shaft Front Tray Cable Pulley

1. Remove the (5) screws securing the HCF Tray's Front Cover.
2. At the front of the HCF Tray, begin to free up movement of the front Tray Cable Pulley (Figure 7).
 - a. Remove the E-Ring on the Lift Shaft.
 - b. Slide the bearing to the rear on the Lift Shaft.
 - c. Front Tray Cable Pulley

NOTE: You will not be able to release the cable ends from underneath the Tray Cable Pulley until you perform the next step, which puts slack in the cable enabling the Lift Shaft to be disengaged from its bracket, and the Tray Cable Pulley moved farther to the right releasing the cable ends.

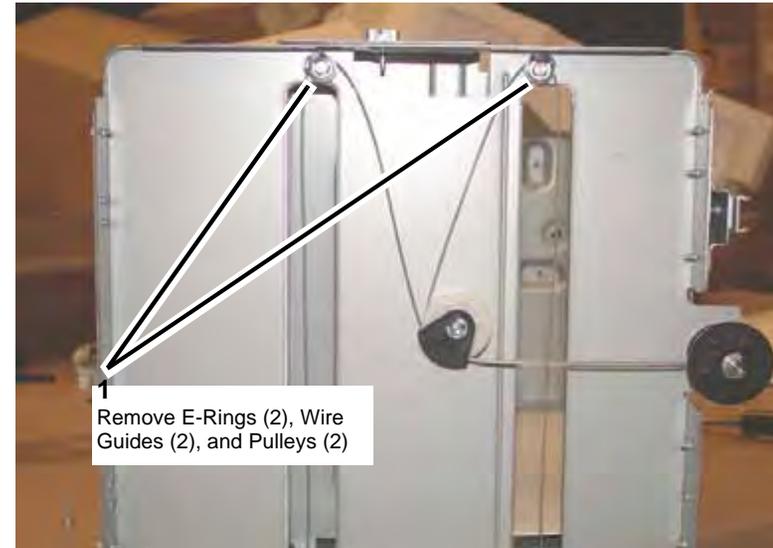
Figure 8 Preparing to remove the Front Tray Cables

3. Remove the E-Rings, Wire Guides, and Pulleys from the front of the HCF Tray (Figure 8).

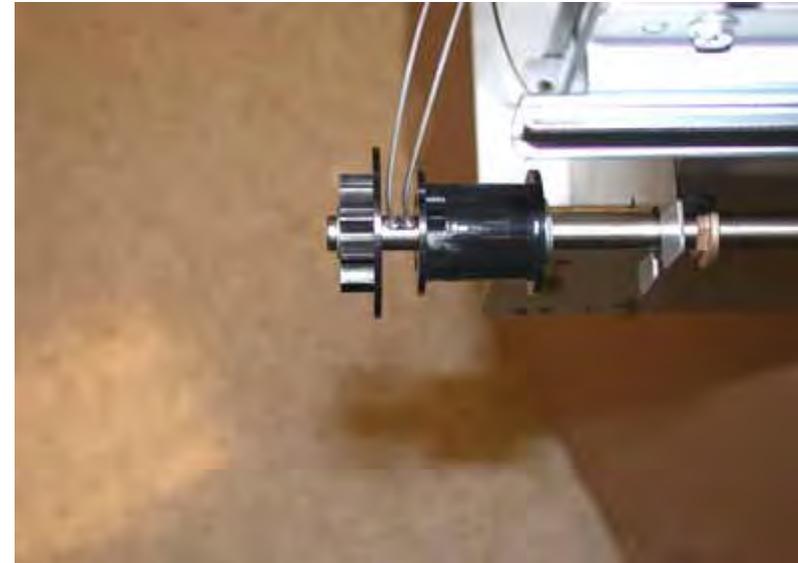
Figure 9 Releasing the Cable ends from the Lift Shaft

4. When both sections of the cable are slack, disengage the Lift Shaft from the frame and slide the Tray Cable Pulley to the front of the Lift Shaft to release the Rear Lift Cable ends that are trapped in the pocket underneath the Tray Cable Pulley (Figure 9).

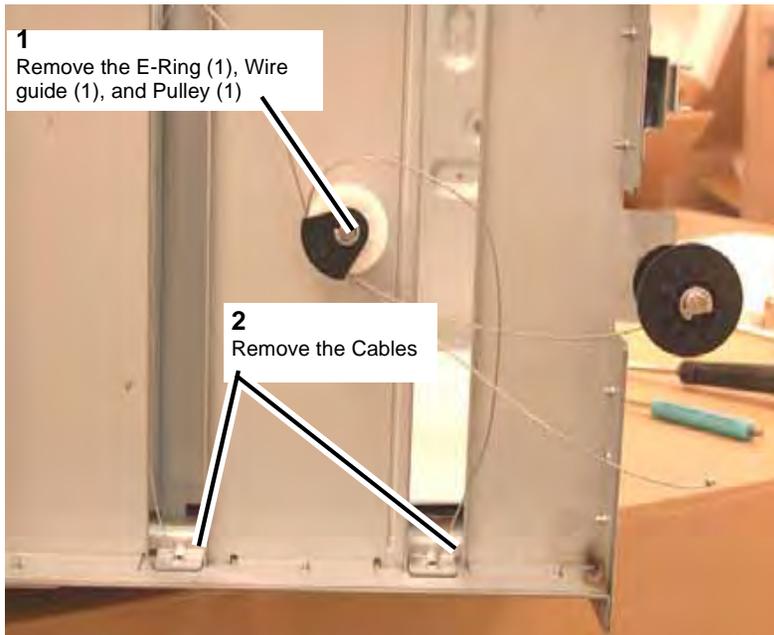
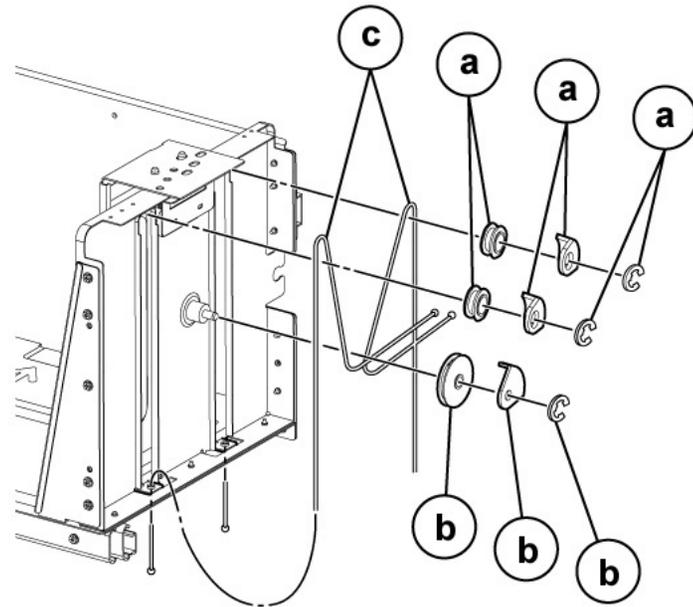
5. Remove the Front Tray Cables (Figure 10, Figure 11).

Figure 10 Removing the Front Tray Cables

Figure 11 Front Tray Cable details

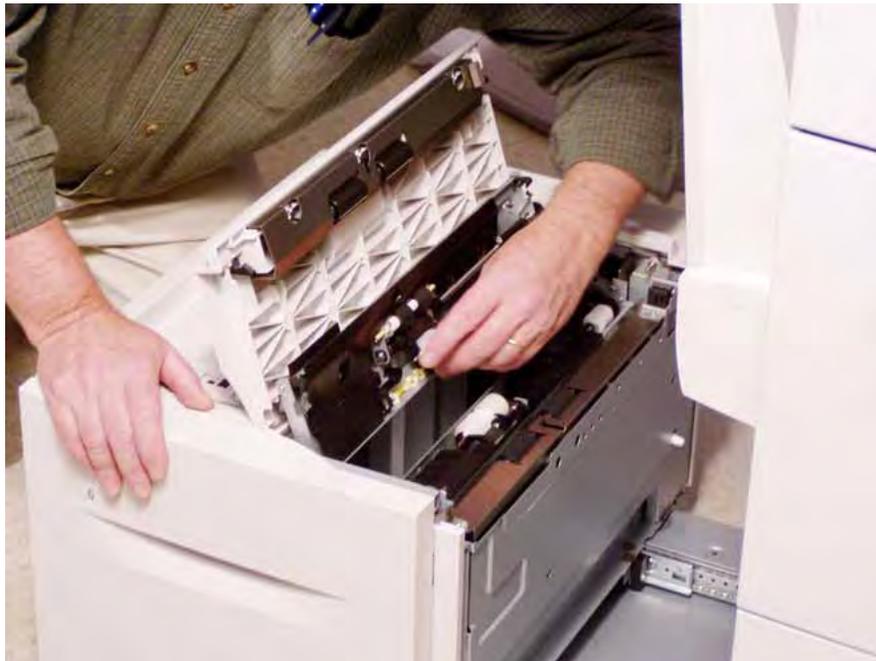
Figure 1 Removing rolls

NOTE: For reference purposes, the single roll in the Upper Feeder Assembly is the Nudger roll. The double roll in the Upper Feeder Assembly is the Feed Roll. The larger double roll in the Lower Feeder component is the Retard Roll.

4. Remove each roll by squeezing the roll's shaft at both ends and lifting the roll up and out of the HCF ([Figure 1](#)).

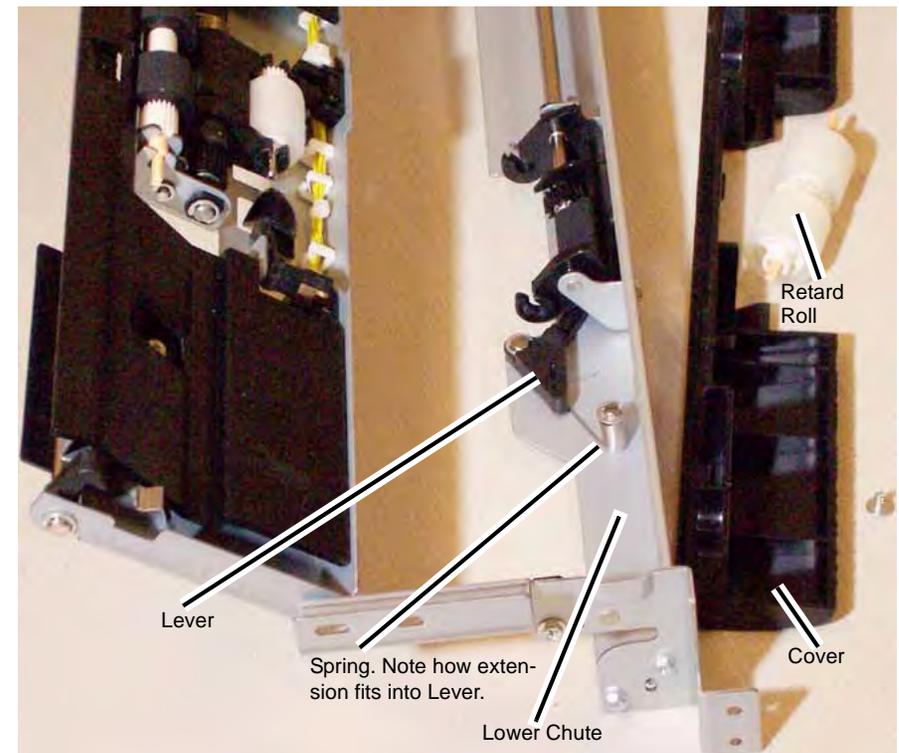
Figure 1 Removing the Retard Lever Spring

1. Switch off the power and disconnect the power cord.
2. Remove the HCF Feeder ([REP 19.2](#))
3. Place the Feeder on a flat surface and release the green Lever to open the Upper Feeder Assembly.
4. Remove the Lower Chute (2 screws).
5. Remove the plastic Cover by removing (4) screws.
6. Remove the Retard Roll.
7. Remove the E-Rings on the Lever and Spring.
8. Remove the Lever.
9. Remove the Spring ([Figure 1](#)).

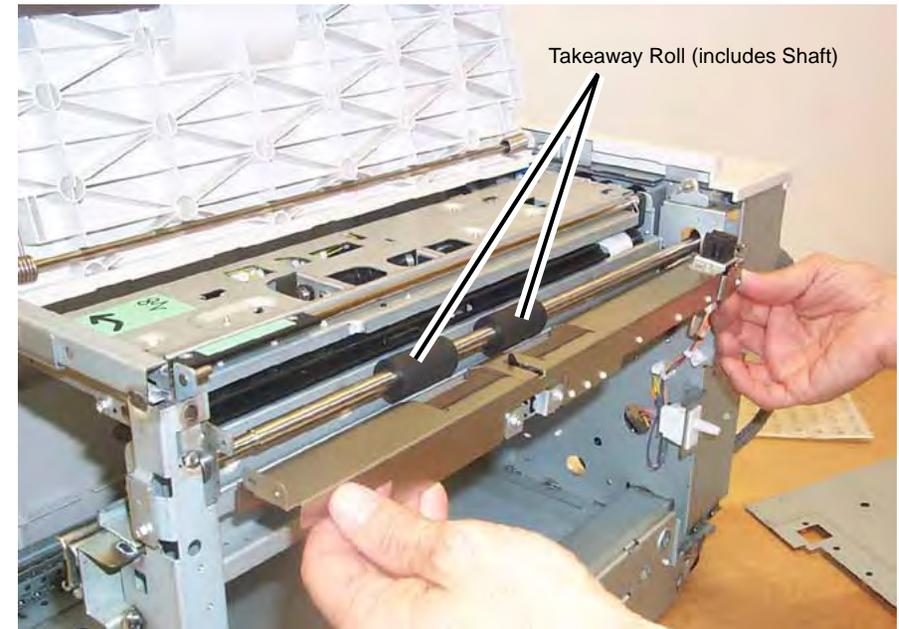
Figure 1 Removing the Lower Chute

1. Switch off the power and disconnect the power cord.
2. Remove the HCF Feed Motor ([REP 19.12](#)).
3. Remove the Lower Chute ([Figure 1](#)).
 - Remove the (2) securing screws.

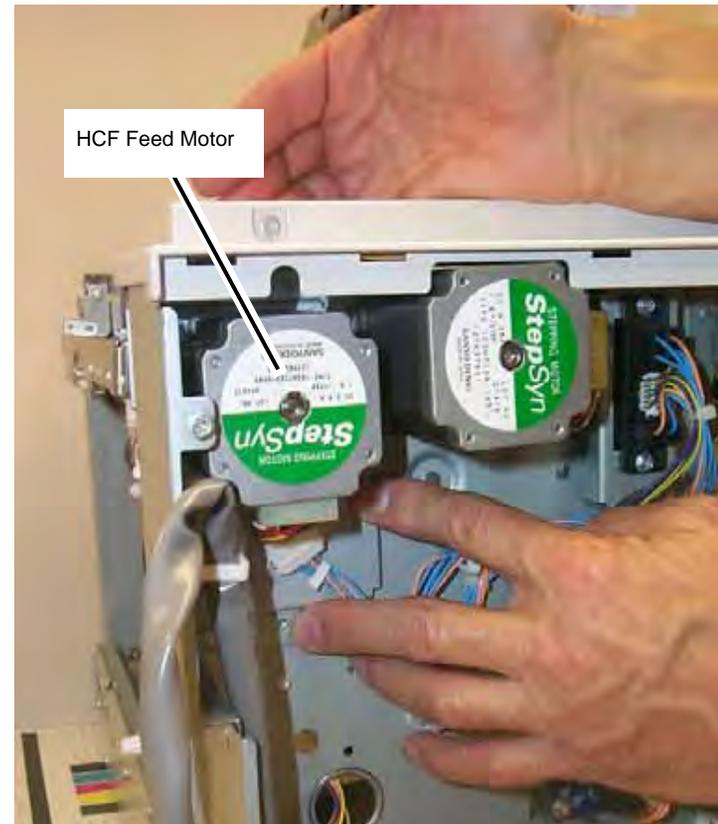
Figure 1 Removing the HCF Feed Motor

NOTE: Be careful when removing the motor as it is meshed to a hidden gear.

4. Supporting the motor with one hand, remove the HCF Feed Motor ([Figure 1](#)).
 - Disconnect the electrical Connector (1).
 - Remove the (2) securing screws.

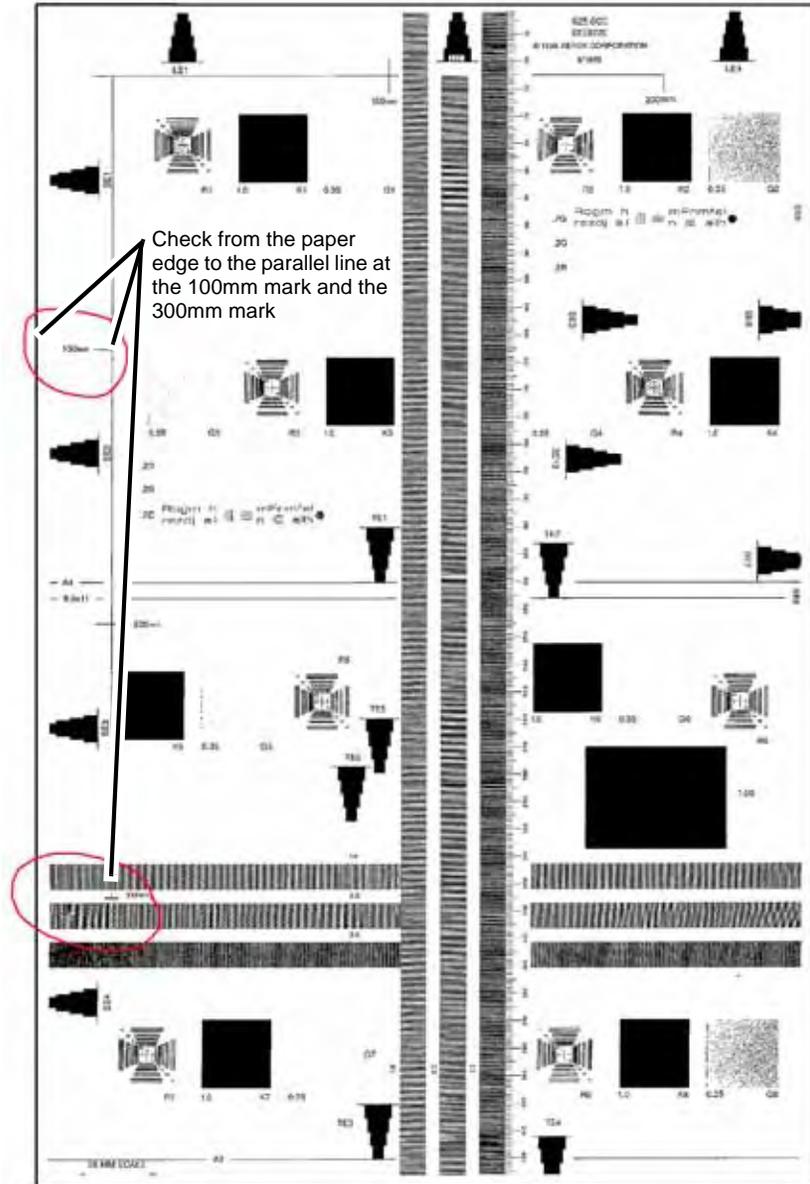
Figure 1 Checking the Skew

4. Place the copy made from the Platen Glass into the DADF and make 3 copies.
5. Check that the difference in the distance between the side and the Edges at the 100mm mark and the 300mm mark in the 3 copies is within 00.5mm. (Figure 1)

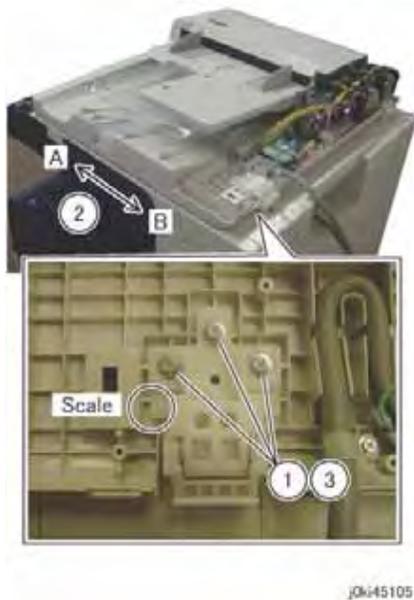
Figure 2 DADF Rear Cover.

1. Remove the DADF Rear Cover. (Figure 2)
2. Adjust the position of the DADF by moving the DADF in direction A or B. (Figure 2)
 - (1) Loosen the screws (x3).
 - (2) Move the DADF in direction A or B.
 - (3) Tighten the screws (x3).

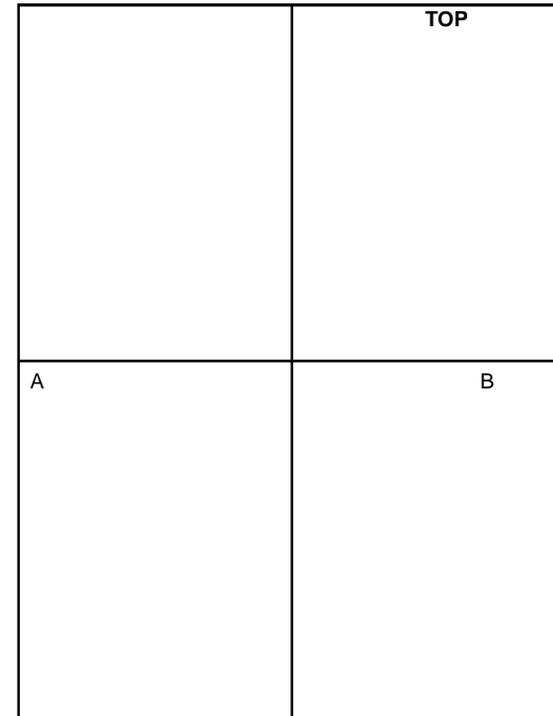
Figure 1 Creating a Test Pattern Original

1. To create a Cross Line Test Pattern, use a plain white sheet of 8.5x11"/A4 paper and fold the sheet precisely in half lengthwise and width wise. Then with a straight edge draw a straight line in the lengthwise crease and a straight line in the width wise crease. Label the top for orientation purposes. ([Figure 1](#))

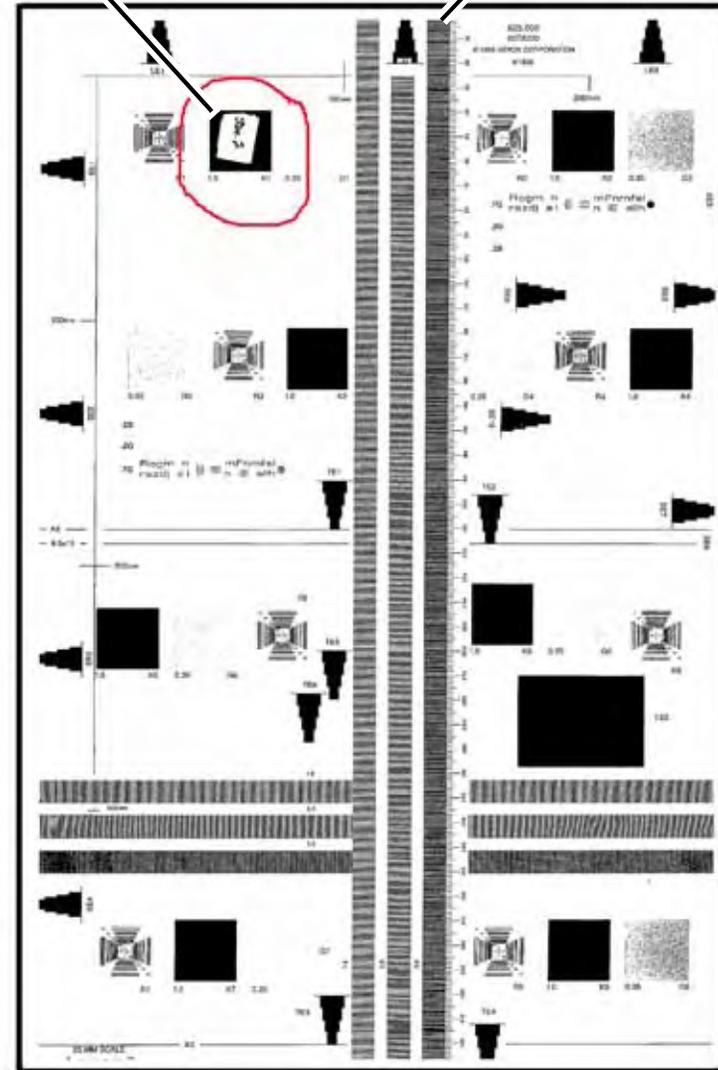
Figure 1 Identifying side 2

Piece of paper to identify side 2

The 10 MM. line is located on this scale

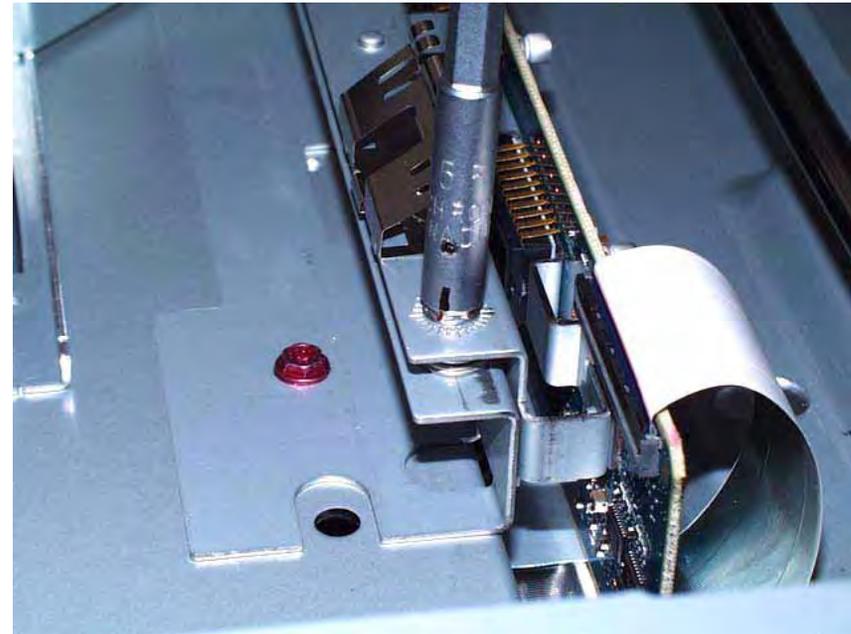
Figure 1 Tool and Front Optics Adjusting Nut

1. Remove the Platen Glass and the Optics cover.
2. Place an index mark on the barrel of a 5.5mm nut driver. The following figure shows the tool and the adjusting nuts. ([Figure 1](#))

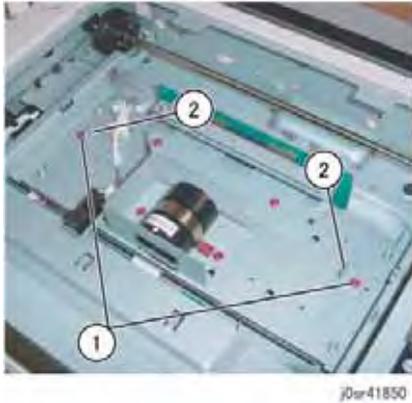
Figure 1 Remove the Alignment Pins

NOTE: When removing the alignment pins, never remove the screws (x4) that secure the Lens Base.

- (1) - Remove the screws (x2).
- (2) - Remove the alignment pins (x2).

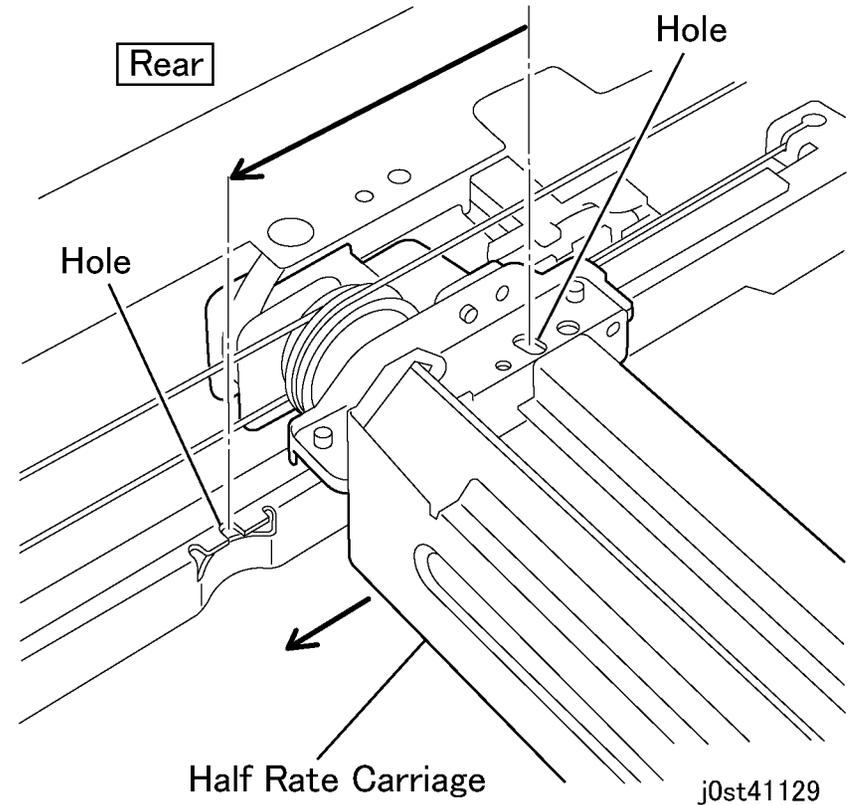
Figure 2 Aligning the Half Rate Carriage 1/3

7. Align the alignment pin holes in the Half Rate Carriage with the holes in the rail ([Figure 2](#)).

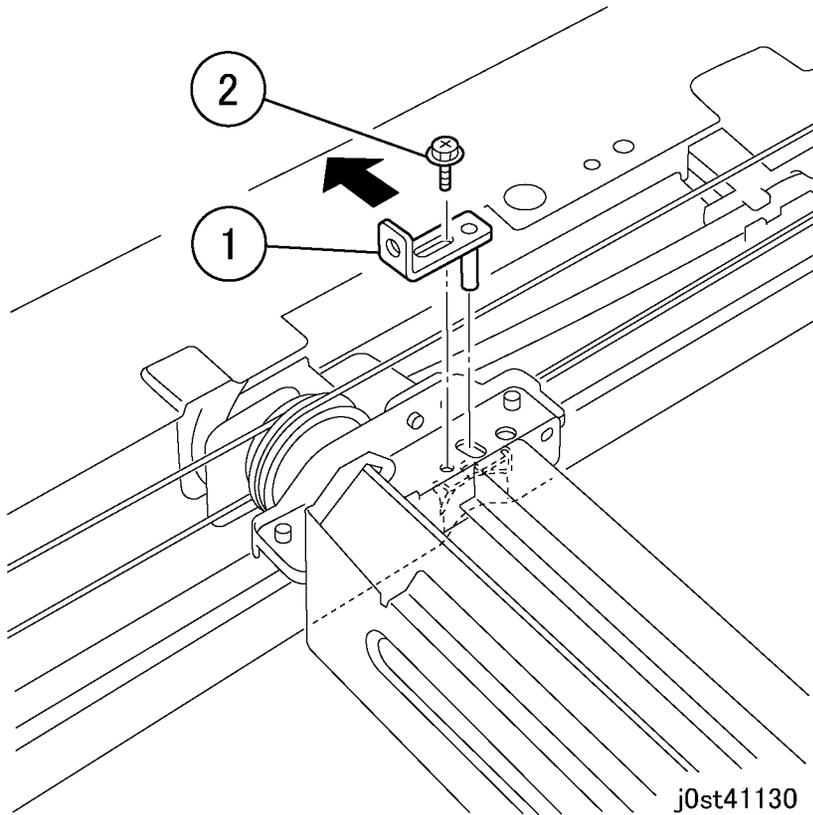
Figure 3 Installing Alignment Pins on Half Rate Carriage

8. Install the alignment pin to the Half Rate Carriage. ([Figure 3](#))

NOTE: Install the alignment pins near the edges (the front tool to the front and the rear tool to the rear). The illustrations show only the rear.

- (1) - Position the alignment pins. (Front/Rear)
- (2) - Secure with a screw.

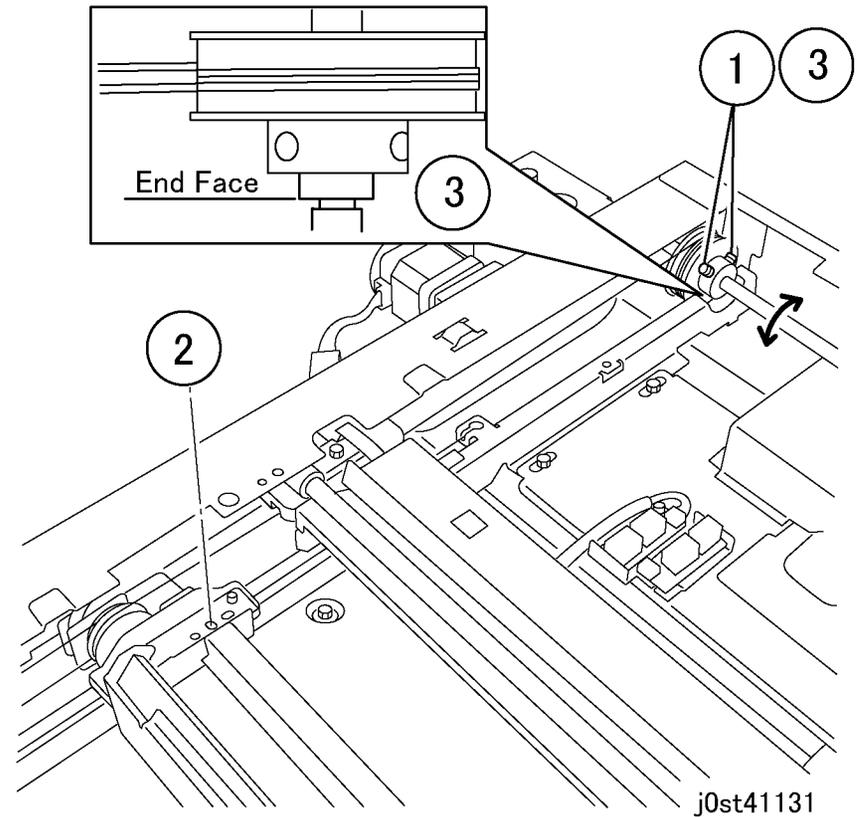
Figure 4 Position Adjustment of Half Rate Carriage

NOTE: The position of the pulley can be changed if the alignment pin holes in the Half Rate Carriage and the rail do not align and the tool cannot be inserted correctly. Perform step 9 if the holes do not align; otherwise proceed to step 10.

9. Adjust the pulleys (Figure 4).
 - (1) - Loosen the set screws (x2).
 - (2) - Turn the Pulley until the tool holes align.
 - (3) - Align the shaft concave with the Pulley end face and tighten the screws (x2).

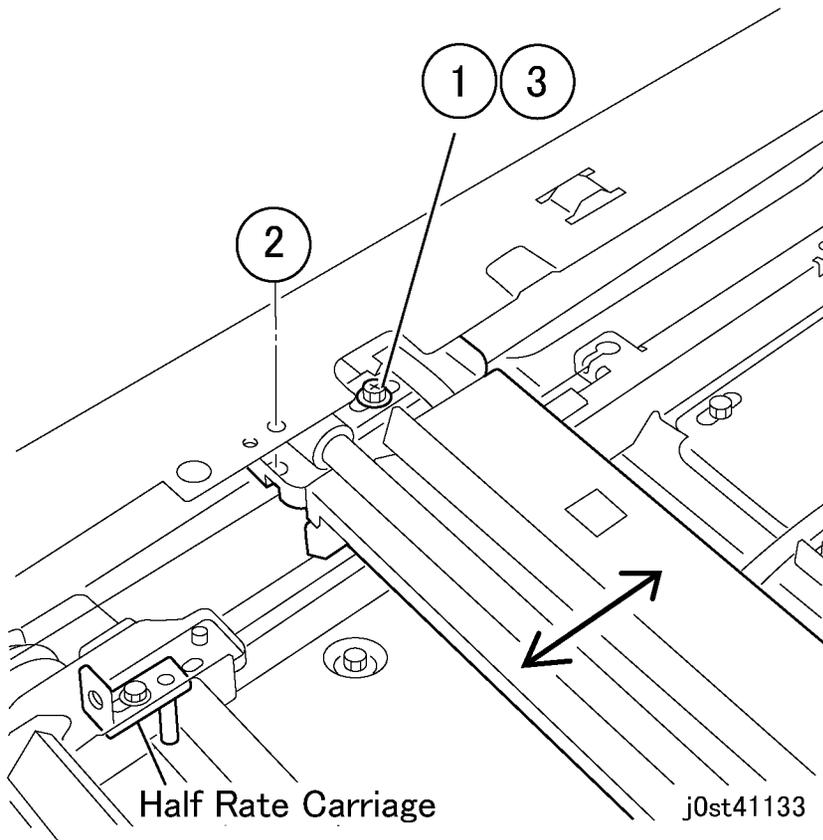
Figure 5 Aligning the Full Rate Carriage

10. Align the Full Rate Carriage (rear) (Figure 5).
 - (1) - Loosen the securing screw of the Carriage Cable.
 - (2) - Move the Full Rate Carriage until the pin holes align.
 - (3) - Tighten the screw.
