WorkCentre 5335 Family Service Documentation

705P01303

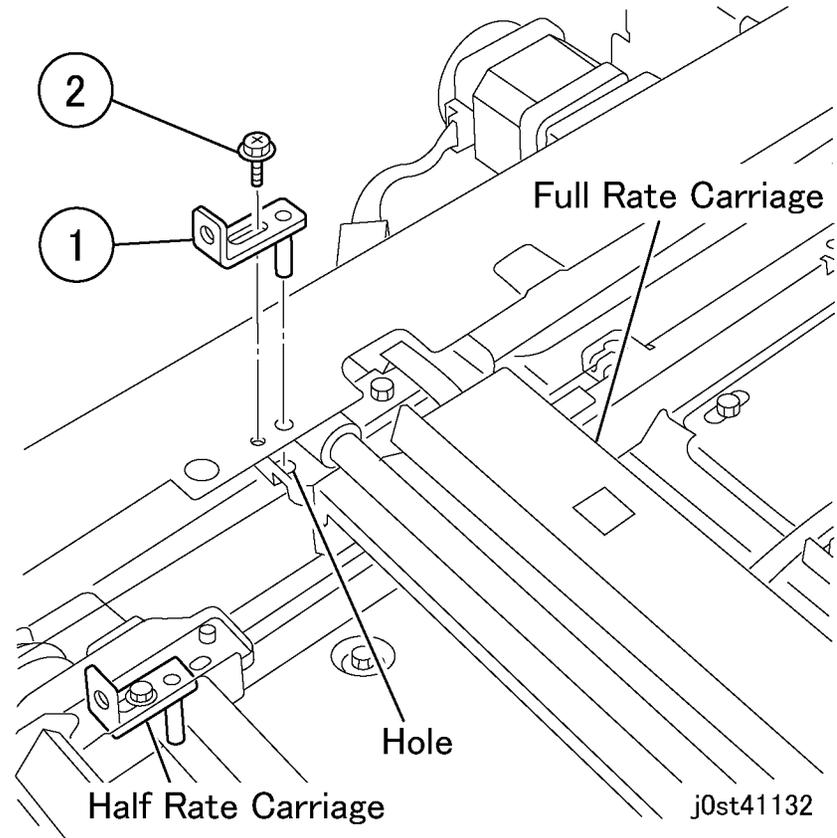
Figure 6 Position Adjustment of Full Rate Carriage

11. Remove the alignment pin from the front of the Half Rate Carriage and install at the rear of the Full Rate Carriage. (Figure 6). The rear tool for Half Rate Carriage remains installed.

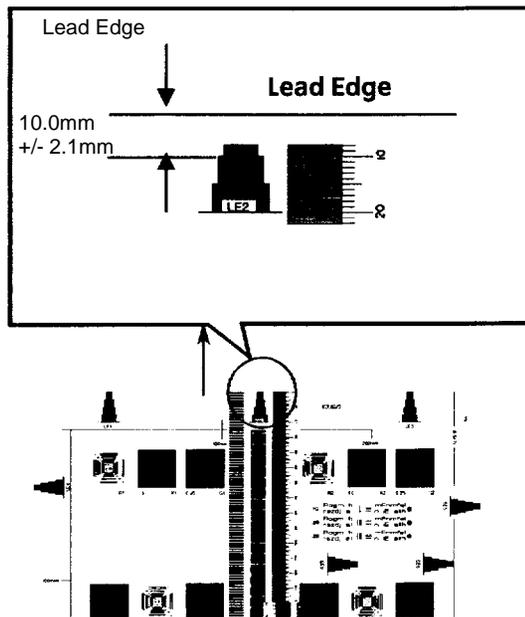
Figure 1 Checking IIT Lead Registration

1. Place the Geometric Test Pattern (82E8220) on the Platen Glass correctly and make copies with the following settings:
 - Copy Mode: Black
 - Paper Size: 11 x 17 in or A3
 - Magnification: 100%
 - No. of Copies: 2
2. On the 2nd copy, check that the distance from the lead edge to the top of Step 3 on the LE2 scale is 10.0mm +/- 2.1mm ([Figure 1](#)).

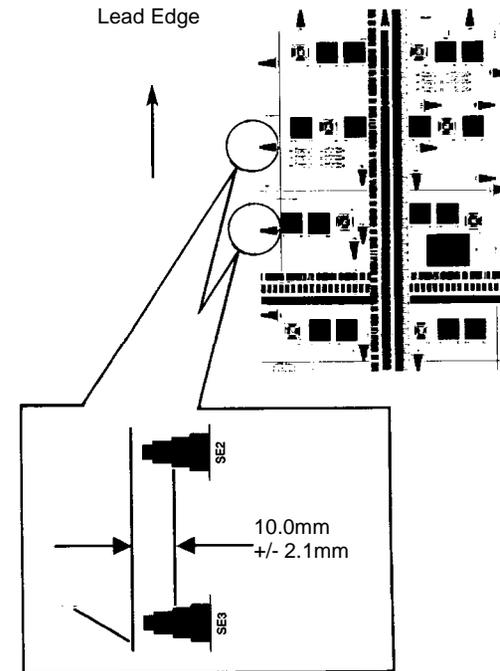
Figure 1 Checking IIT Side Edge Registration

1. Load 11 x 17 in. or A3 paper into Tray 2.
2. Place the Geometric Test Pattern (82E8220) on the Platen Glass correctly and make copies with the following settings:
 - Copy Mode: Black
 - Paper Tray: Tray 2
 - Magnification: 100%
 - No. of Copies: 2
3. On the 2nd copy, check that the distance from the lead edge to the top of Step 3 on the SE2 and SE3 scales is 10.0mm +/- 1.6mm ([Figure 1](#)).

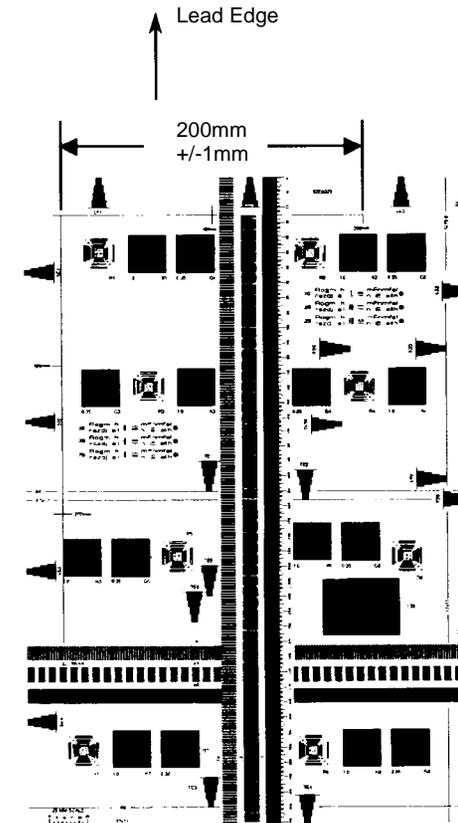
Figure 1 Checking Horizontal Magnification

1. Place the Geometric Test Pattern (82E8220) on the Platen Glass and make a copy using the following copy mode settings:
 - Copy Mode: Black
 - Document Type: Text/Photo
 - Paper: 11 x17 in. or A3
 - Magnification: 100%
 - No. of Copies: 2
2. Check the 2nd copy for the following:
3. **Check horizontal magnification (Figure 1):**
Measure the 200mm line running from near LE1 to near LE3. Check that the dimension is 200mm \pm 1mm.

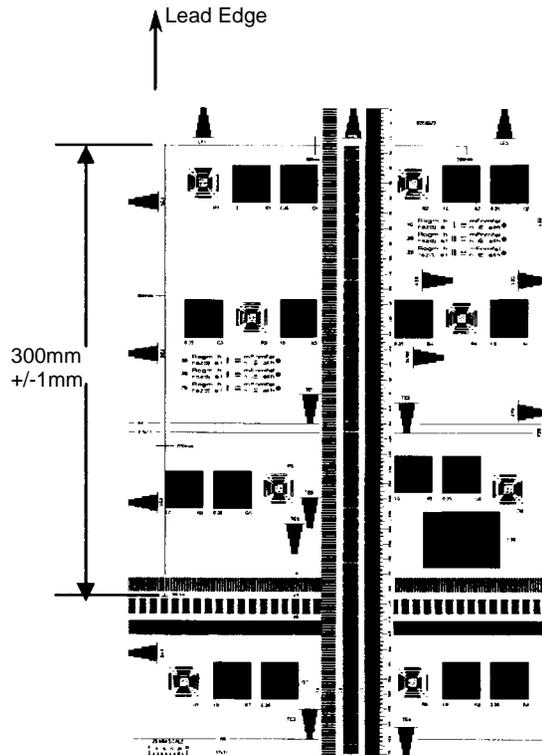
Figure 2 Checking Vertical Magnification

4. **Check vertical magnification (Figure 2):**
Measure the 300mm line running from near LE1 to the trail edge of the 1.8lp ladder. Check that the dimension is 300mm \pm 1mm.

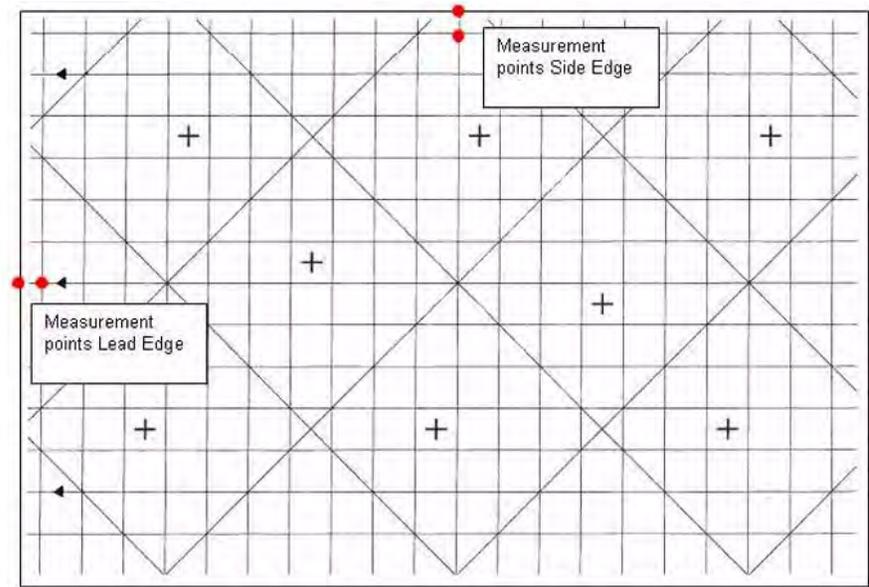
Figure 1 Test Pattern Measurement Points

13. Take the third print and measure from the lead edge to point A (as shown on [Figure 1](#)). Point A is at the intersection of the 7th line from the side edge and the first line from the lead edge.

14. If the measured value is not 10 +/- 1.5mm, perform the **Adjustment**. If the Check is OK, repeat steps 5 through 8 for Trays 2 - 5.
15. After all trays are set, proceed to **Checking Side 2 Lead Edge Registration**.

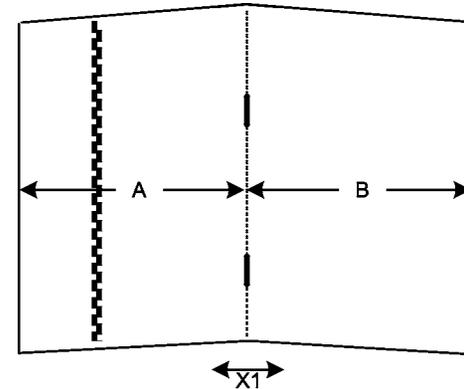
Figure 1 Measurements

1. Enter the Service Rep. Mode ([Accessing UI Diagnostics](#)) and select **Finisher Adjustment** (on second page).
2. Select **Adjust Punch Position/Booklet Fold Position**.
3. Select choice #3 or #4, depending on the paper size, then select **Change Settings**.
4. Select **Sample Printout**.
5. Select a paper tray with the appropriate paper, then press **Start**. The selection must match the choice made above.
6. Measure the distance between the crease and the edges of the sheet ("A" and "B" on [Figure 1](#)). The measurements should be equal, +/- 3.5 mm for A4/Letter size paper; 4 mm for all other sizes.

7. Measure the distance between the crease and the staples ("X1" on [Figure 1](#)). The measurements should be less than 2.5 mm.
8. If either measurement is not within spec, perform the Adjustment.

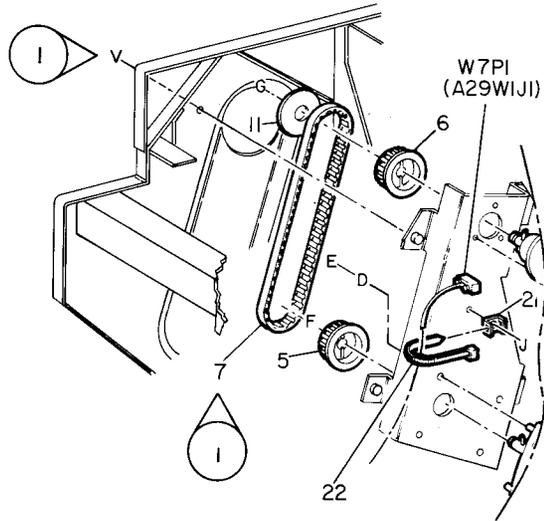
Figure 1 With Tag Symbol

A Tag number within a circle pointing to an item number shows that the part has been changed by the tag number within the circle (Figure 1). Information on the modification is in the Change Tag Index.

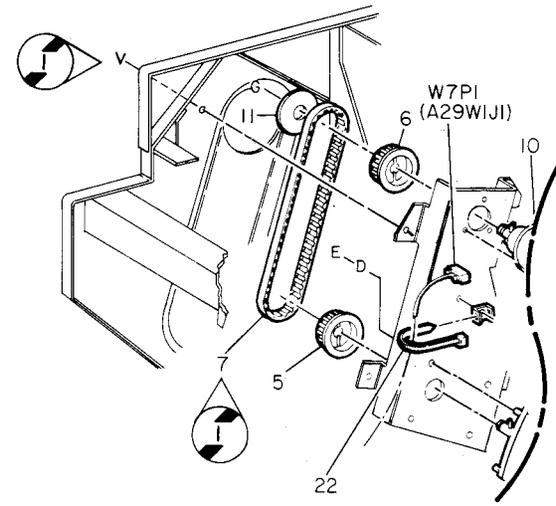
Figure 2 Without Tag Symbol

A Tag number within a circle having a shaded bar and pointing to an item number shows that the configuration of the part shown is the configuration before the part was changed by the Tag number within the circle (Figure 2).

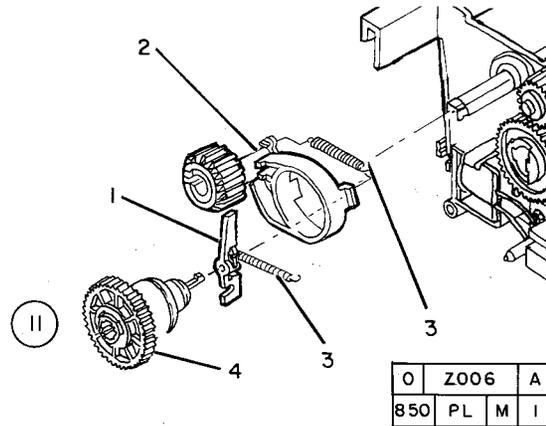
Figure 3 Entire Drawing With Tag Symbol

A tag number within a circle with no apex shows that the entire drawing has been changed by the tag number within the circle (Figure 3). Information on the modification is in the Change Tag Index.

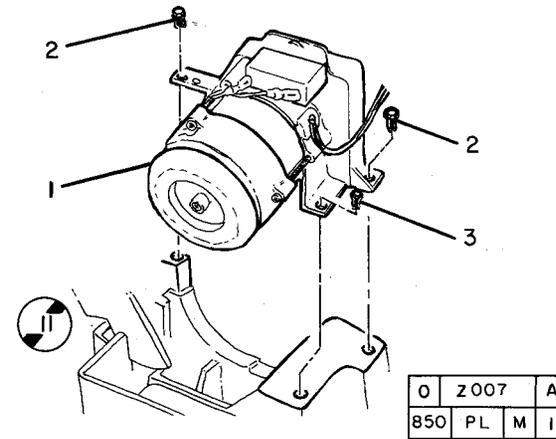
Figure 4 Entire Drawing Without Tag Symbol

A tag number within a circle with no apex and having a shaded bar shows that the entire drawing was the configuration before being changed by the tag number within the circle (Figure 4).

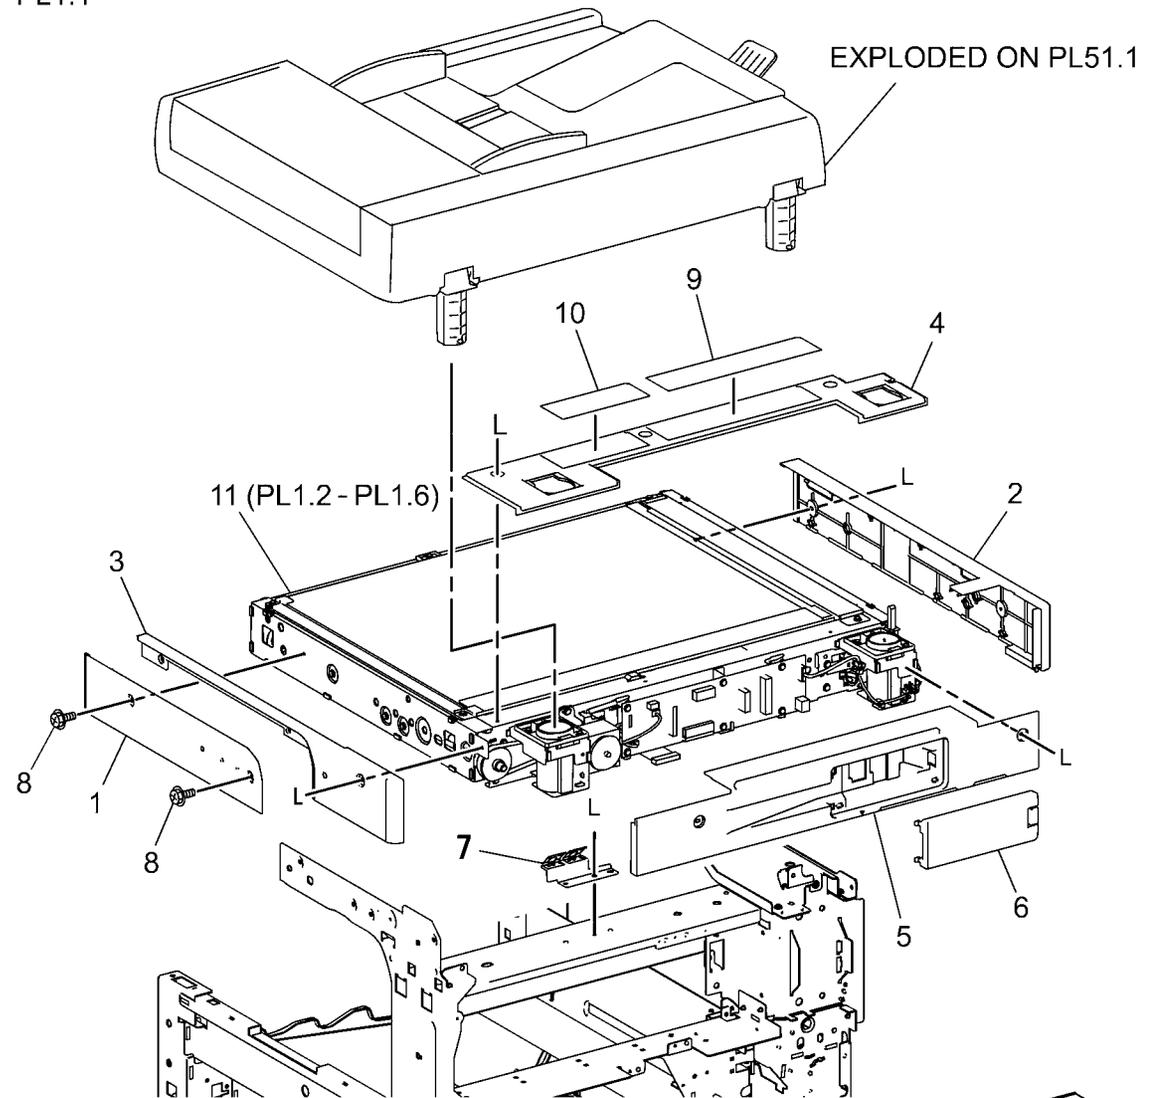
PL 1.1 IIT Covers

Item	Part	Description
1	–	Right Outer Cover
2	–	Left Cover
3	–	Right Cover
4	–	Top Cover
5	–	Rear Cover
6	848E49150	DADF Connector Cover
7	–	Transport Bracket Assembly
8	–	Screw
9	–	Caution Label
10	–	Label
11	062K21136	IIT Assembly

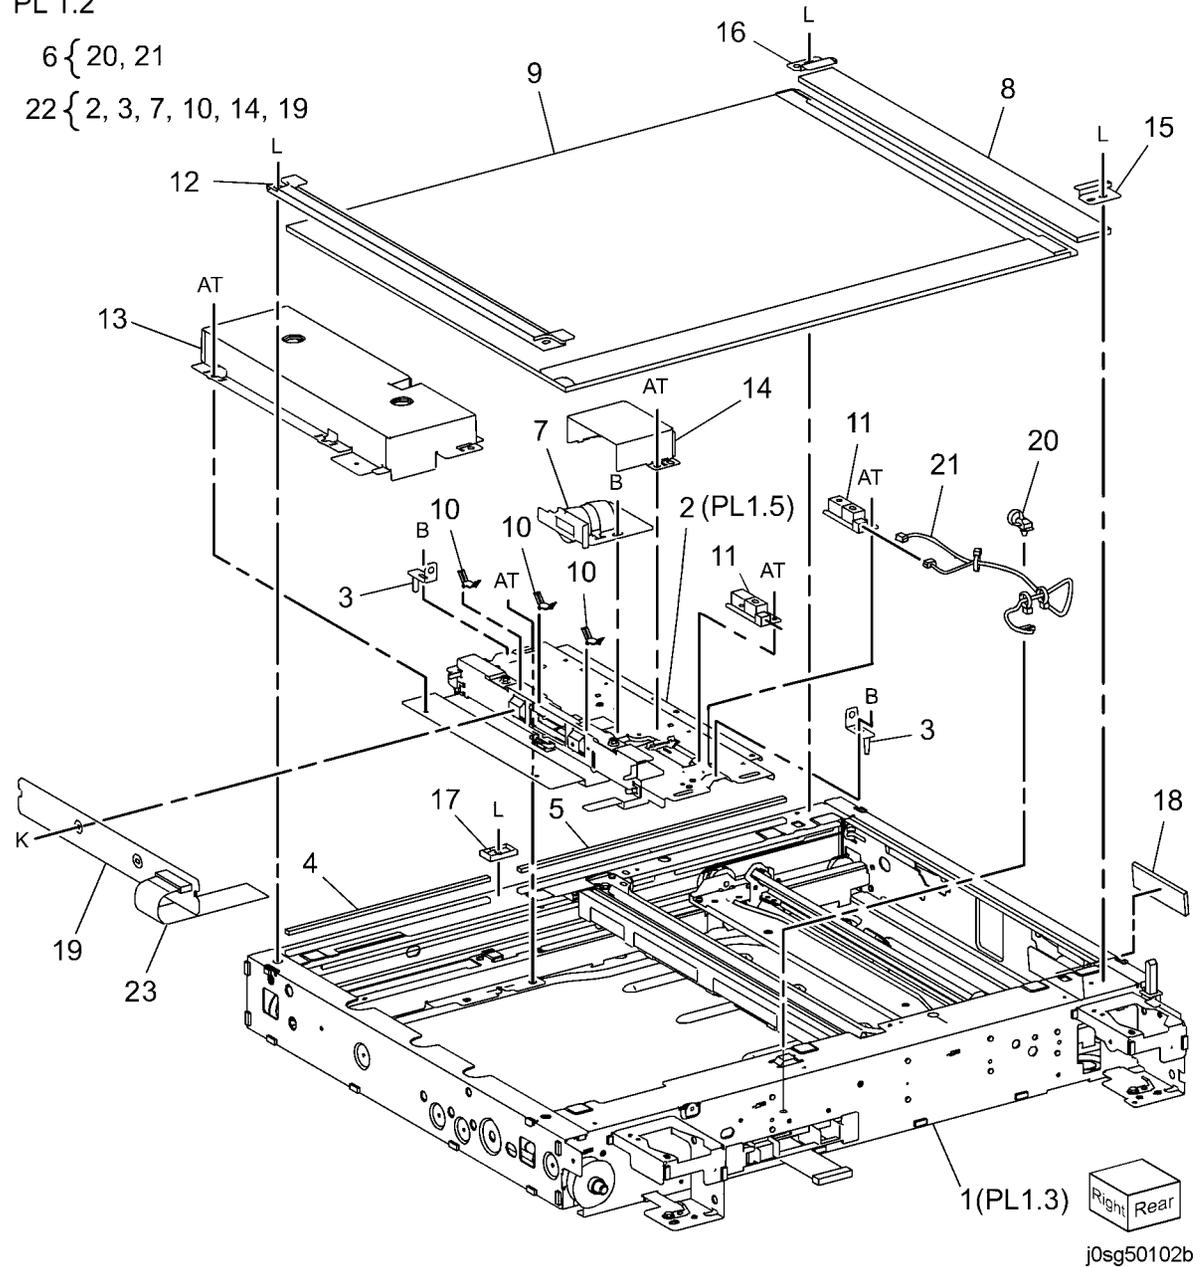
PL 1.2 CCD Lens Assembly/Platen Glass

Item	Part	Description
1	-	IIT Assembly
2	-	CCD Lens Base Plate Assembly (P/O PL 1.2 Item 22)
3	-	Pin Assembly (P/O PL 1.2 Item 22)
4	-	Right Seal
5	-	Left Seal
6	-	Wire Harness Assembly (Includes Items 20, 21) (REP 6.7)
7	-	CCD Lens Assembly (P/O PL 1.2 Item 22) (REP 6.4)
8	090K93320	CVT Platen Glass (REP 6.3)
9	090K93330	Platen Glass (REP 6.3)
10	-	Conductor (P/O PL 1.2 Item 22)
11	130K64150	APS Sensor
12	815E58941	Right Plate
13	-	Lens Cover Assembly
14	-	Lens Bracket (P/O PL 1.2 Item 22)
15	849E15760	Rear Glass Support
16	849E22651	Front Glass Support
17	849E17910	Glass Support
18	-	Data Plate
19	-	PWB Assembly (P/O PL 1.2 Item 22)
20	-	Cable Band (P/O PL 1.2 Item 6)
21	-	Wire Harness Assembly (P/O PL 1.2 Item 6)
22	604K57500	Lens/CCD Kit (Includes Items 2, 3, 7, 10, 14, 19) (REP 6.4)
23	117E31780	CCD Flexible Flat Cable

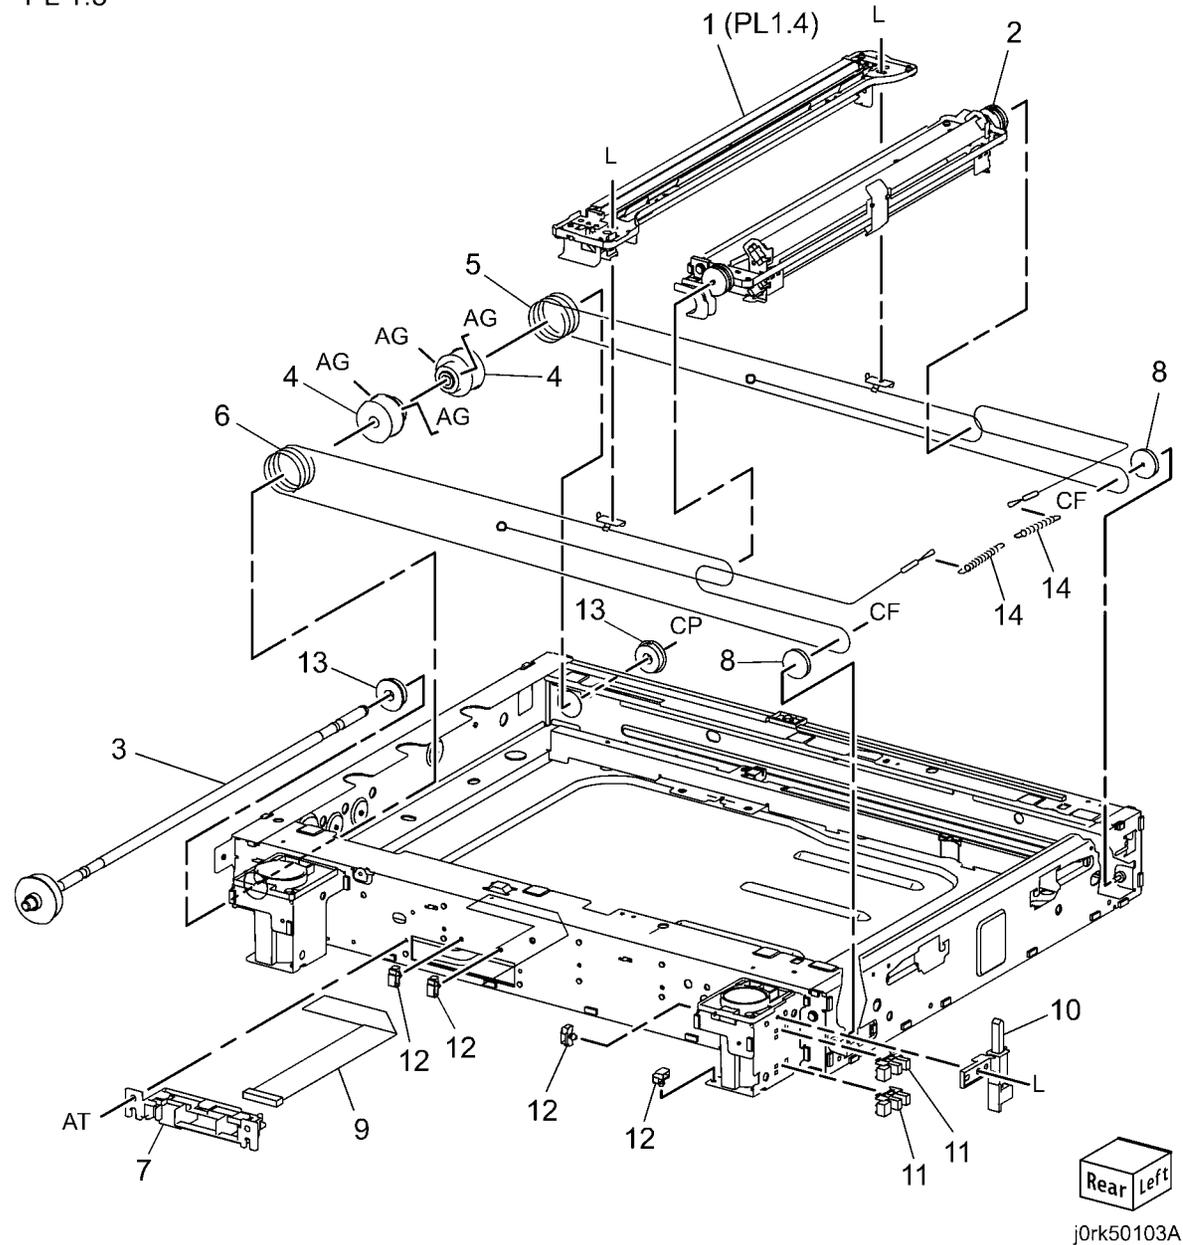
PL 1.3 Full/Half Rate Carriage

Item	Part	Description
1	041K96191	Full Rate Carriage Assembly (ADJ 6.2)
2	041K96223	Half Rate Carriage Assembly (ADJ 6.2)
3	006K88780	Capstan Shaft
4	020E47040	Capstan Pulley
5	012K96780	Front Carriage Cable (REP 6.5)
6	012K96790	Rear Carriage Cable (REP 6.5)
7	-	Cord Holder (P/O PL 1.1 Item 11)
8	020E37030	Pulley
9	117E31780	Cable
10	120K92581	Actuator Assembly
11	930W00123	Platen Sensor, Angle Sensor
12	920W01235	Clamp
13	013E23640	Bearing
14	809E91540	Spring

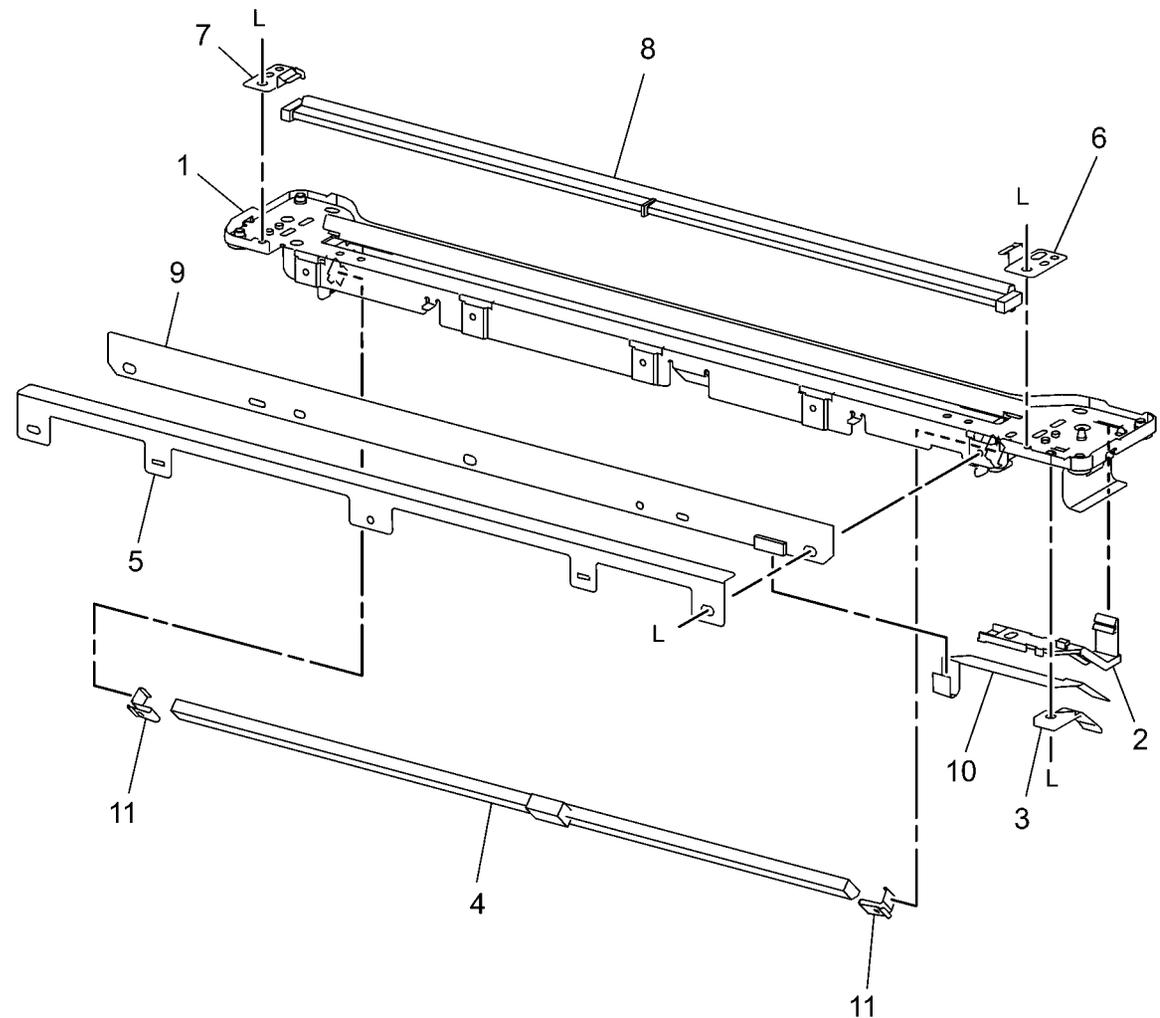
PL 1.4 Full Rate Carriage

Item	Part	Description
1	-	Full Rate Carriage (P/O PL 1.3 Item 1)
2	-	Harness Guide (P/O PL 1.3 Item 1)
3	-	Slide Harness Guide (P/O PL 1.3 Item 1)
4	-	No 1 Mirror (P/O PL 1.3 Item 1)
5	-	LED Bracket (P/O PL 1.3 Item 1)
6	-	Guide Spring (P/O PL 1.3 Item 1)
7	-	Guide Spring (P/O PL 1.3 Item 1)
8	-	Light Guide (P/O PL 1.3 Item 1) (REP 6.8)
9	960K51290	LED Lamp PWB (REP 6.6)
10	-	Slide Cord (P/O PL 1.3 Item 1)
11	-	Clip (P/O PL 1.3 Item 1)

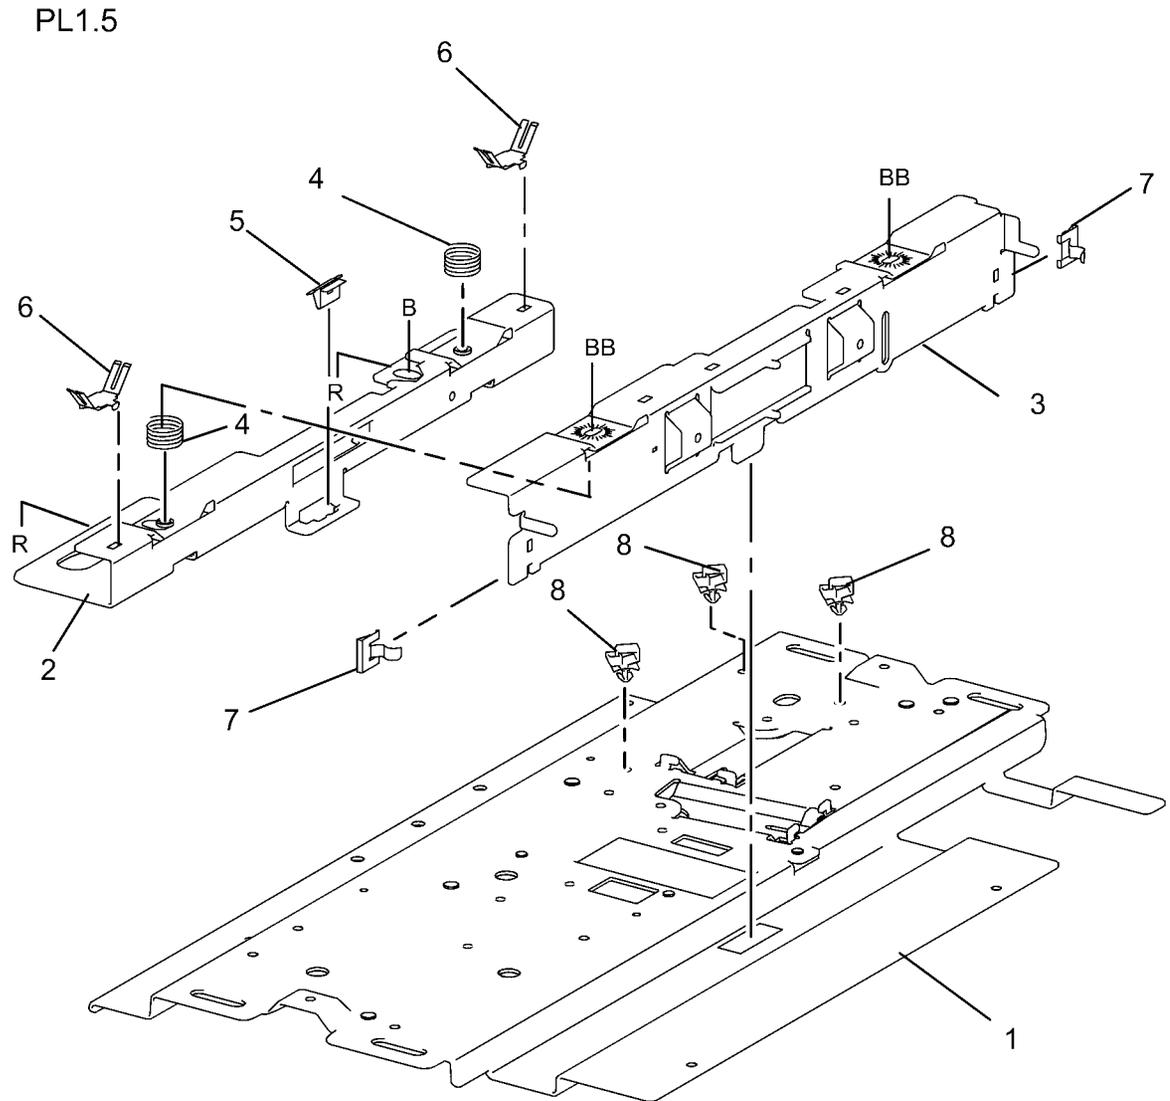
PL 1.5 CCD Lens Base Plate

Item	Part	Description
1	–	Base Plate (P/O PL 1.2 Item 22)
2	–	Stage Plate (P/O PL 1.2 Item 22)
3	–	CCD Plate (P/O PL 1.2 Item 22)
4	–	Spring (P/O PL 1.2 Item 22)
5	–	Spring (P/O PL 1.2 Item 22)
6	–	Conductor (P/O PL 1.2 Item 22)
7	–	PWB Conductor (P/O PL 1.2 Item 22)
8	920W01235	Clamp

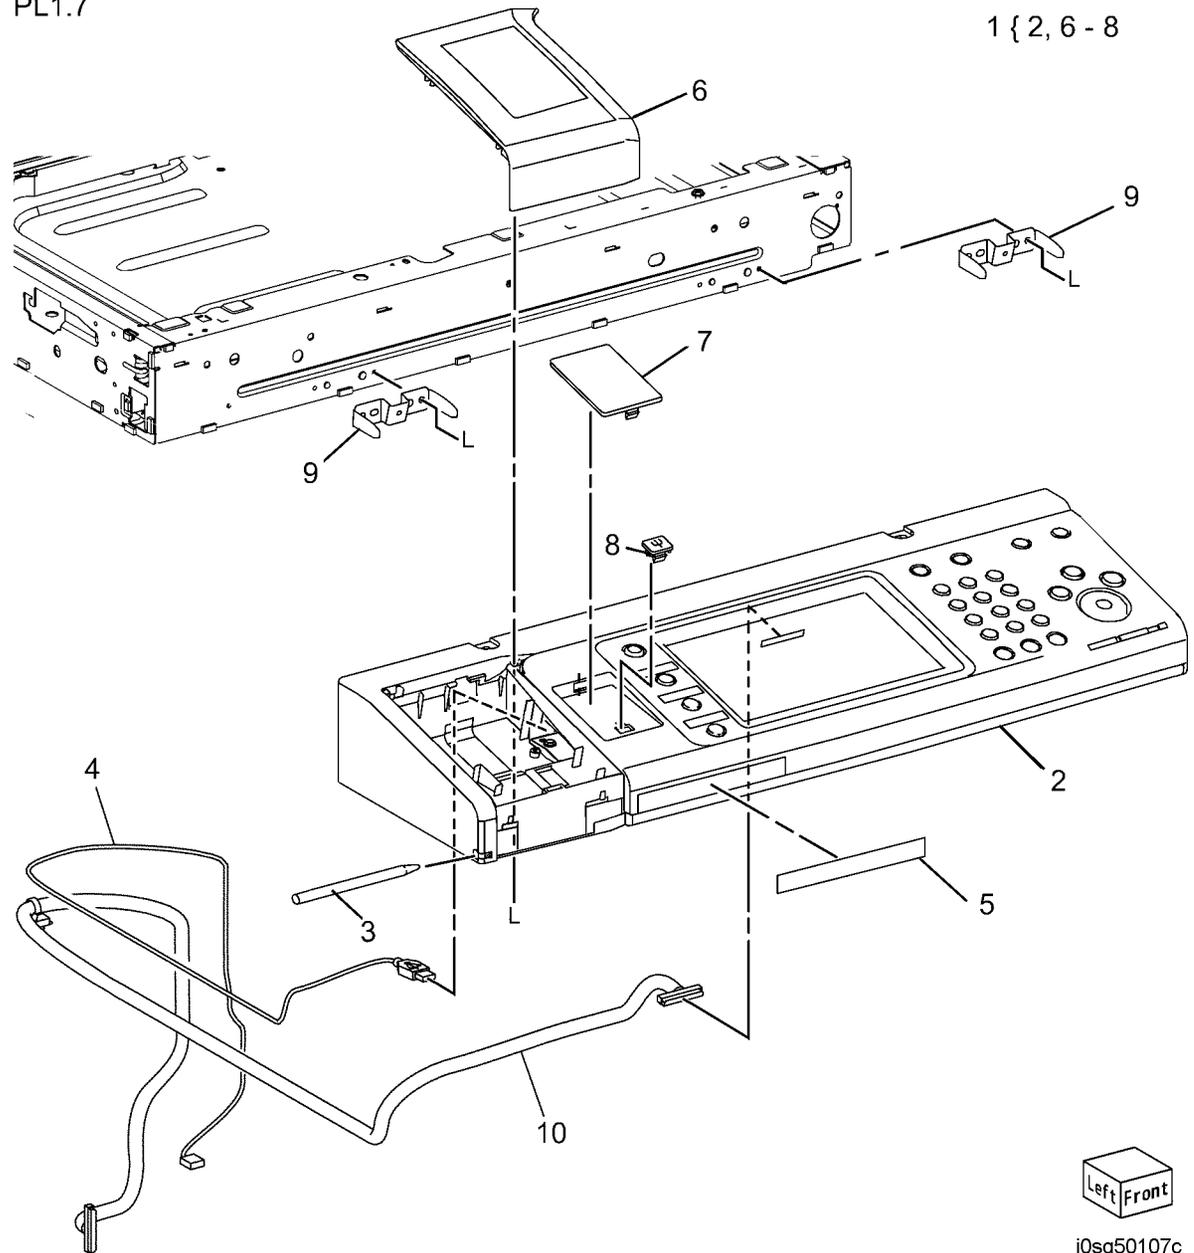
PL 1.7 Control Panel

Item	Part	Description
1	848K57411	Control Panel Assembly (XE) (Includes Items 2, 6-9)
-	848K57401	Control Panel Assembly (XC) (Includes Items 2, 6-9) (REP 6.11)
2	-	Control Panel (P/O PL 1.7 Item 1)
3	-	Stylus (Not Spared)
4	-	UI Cable (Not Spared)
5	604K70430	Name Label
6	-	Clip Cover (P/O PL 1.7 Item 1)
7	-	USB Cover (P/O PL 1.7 Item 1)
8	-	USB Cap Cover
9	868E43540	Bracket
10	962K93370	UI USB Cable

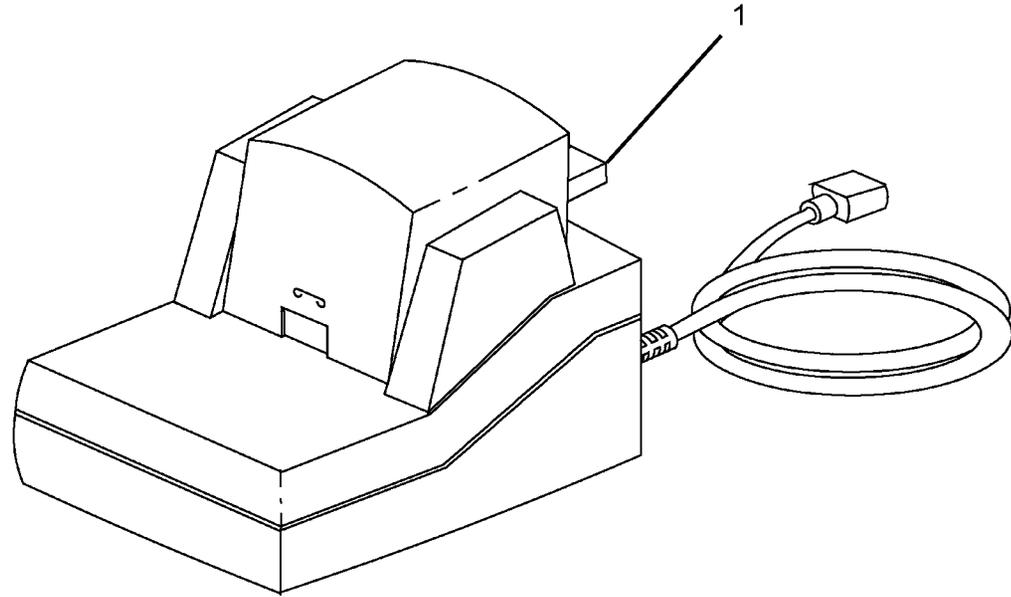
PL 1.9

Item	Part	Description
1	604K35710	Convenience Stapler (110V)
-	604K35700	Convenience Stapler (220V)

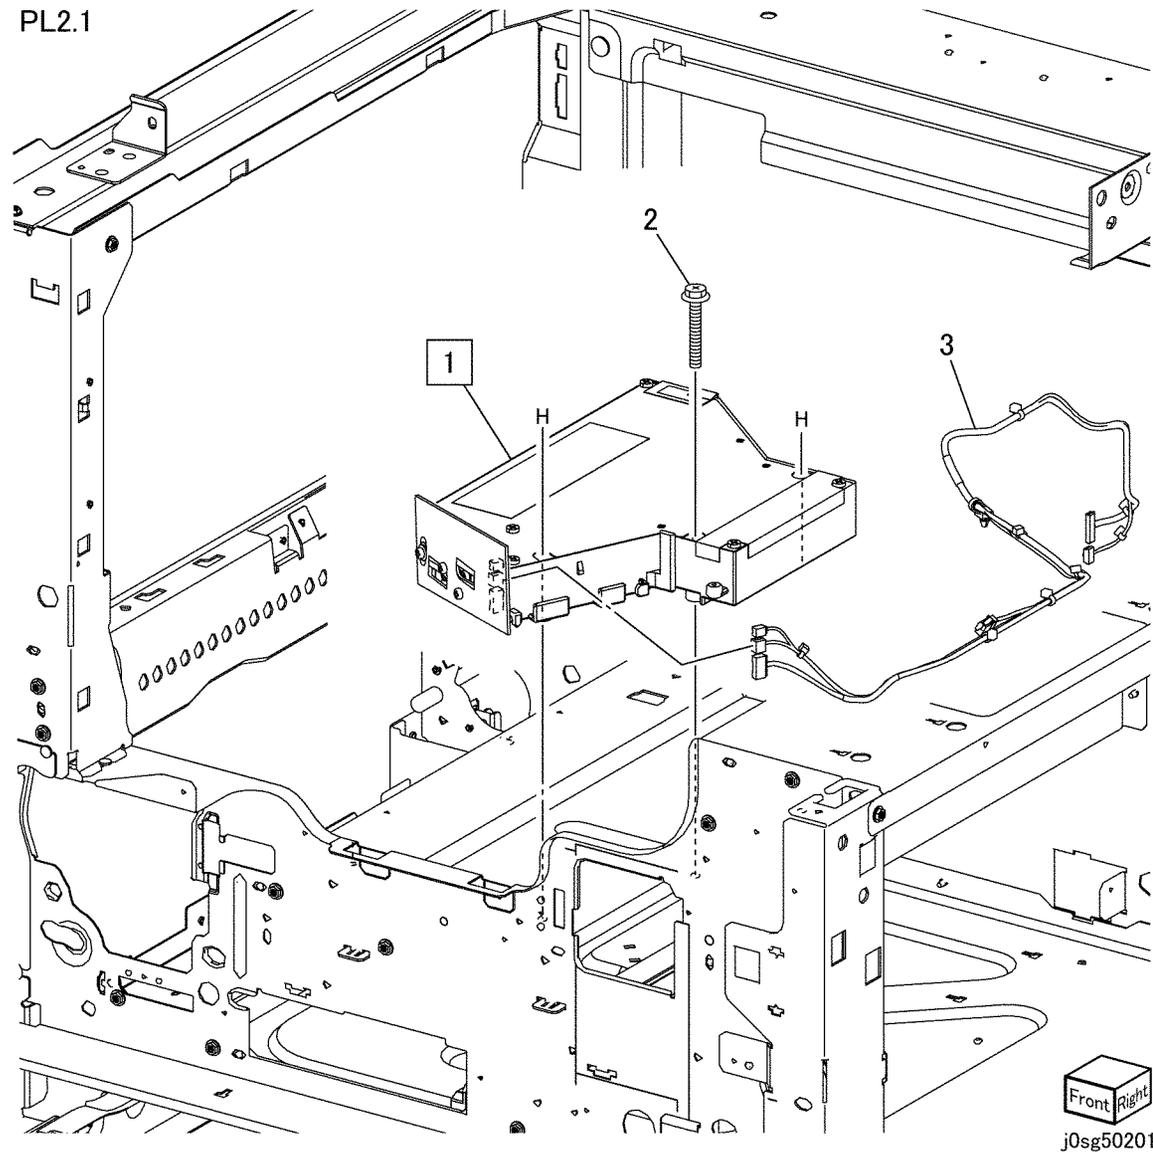
PL 2.1 ROS

Item	Part	Description
1	604K68250	ROS Assembly (REP 6.2)
2	-	Screw (M3X38) (Not Spared)
3	-	Wire Harness (Not Spared)

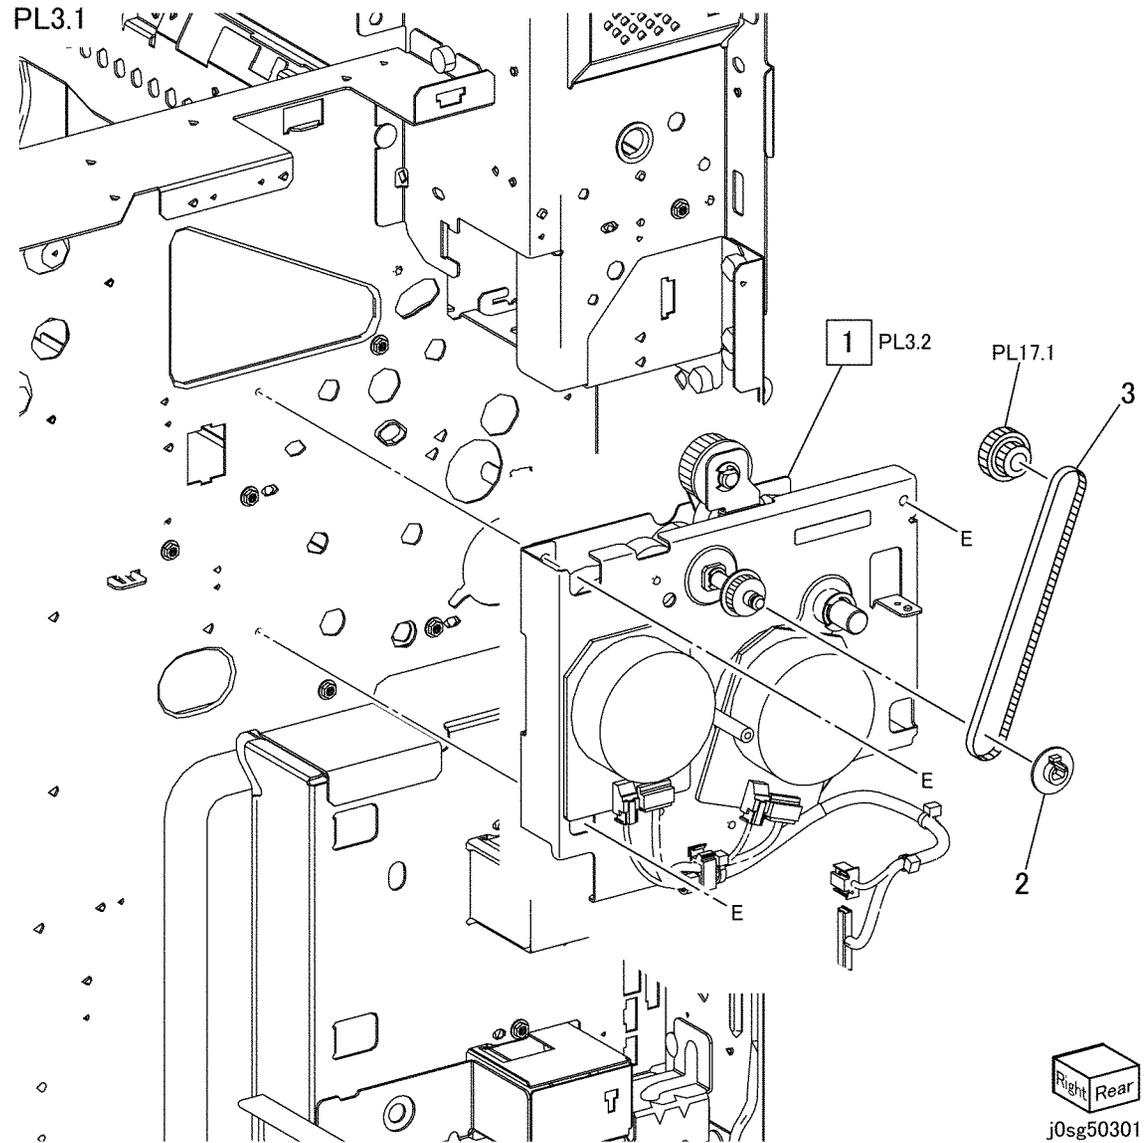
PL 3.1 Main Drive (1 of 2)

Item	Part	Description
1	007K17830	Main Drive Assembly (REF: PL 3.2) (REP 4.1)
2	-	Flange (Not Spared)
3	-	Belt (Not Spared)

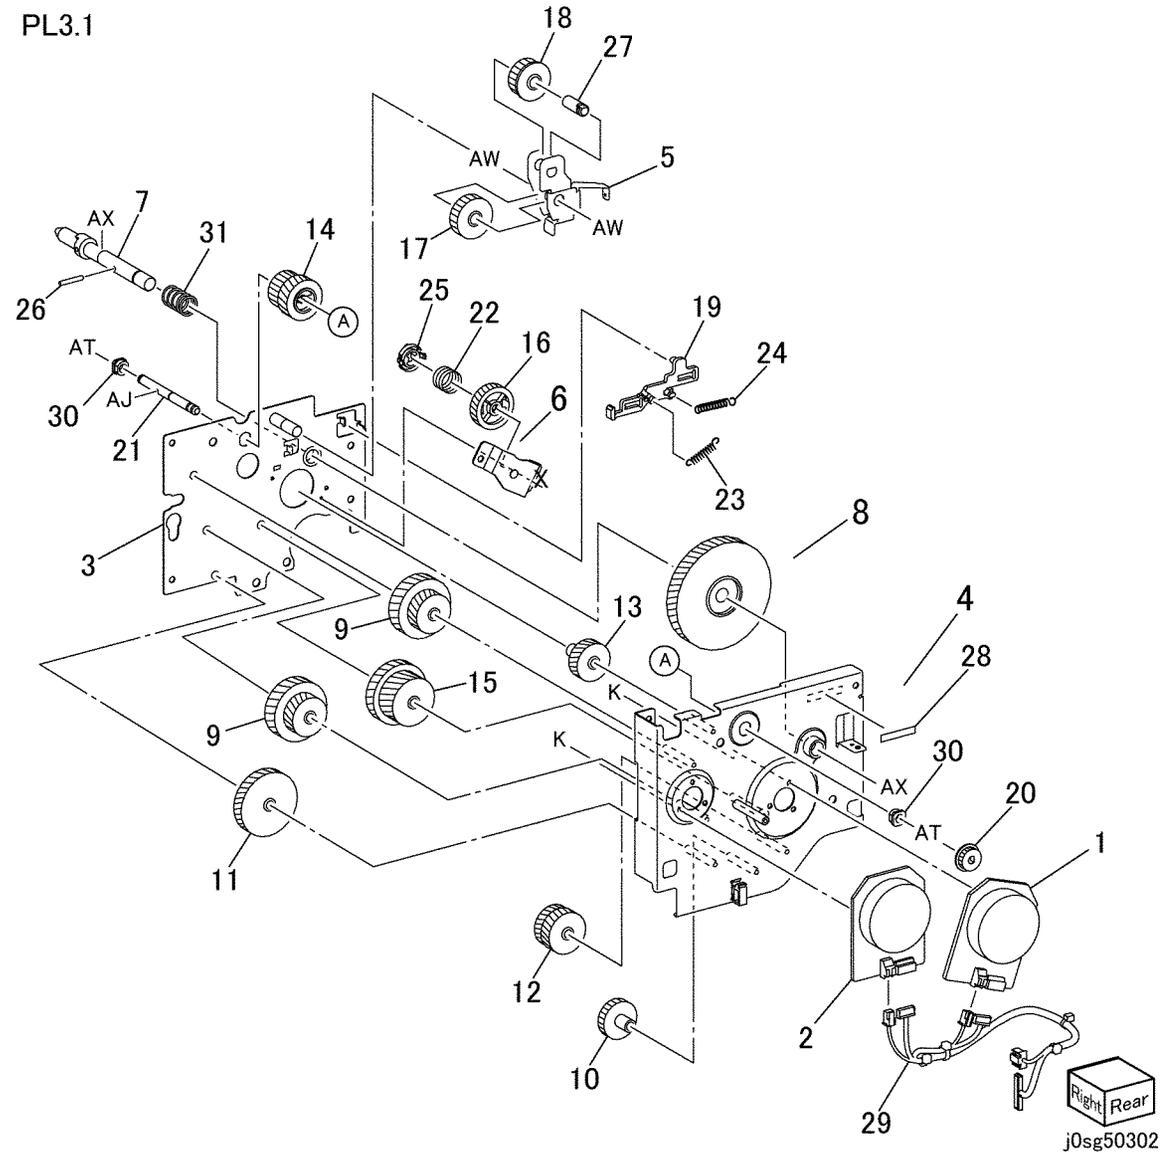
PL 3.2 Main Drive (2 of 2)

Item	Part	Description
1	127K64040	Drum Motor
2	127K63770	Main Motor
3	-	Bracket (Not Spared)
4	-	Bracket (Not Spared)
5	-	Bracket (Not Spared)
6	-	Bracket (Not Spared)
7	-	Drum Shaft Assembly (with Item 31) (Not Spared)
8	-	Gear (Not Spared)
9	-	Gear (80T/28T) (Not Spared)
10	-	Gear (Not Spared)
11	-	Gear (Not Spared)
12	-	Gear (Not Spared)
13	-	Gear (27T) (Not Spared)
14	-	Gear (Not Spared)
15	-	Gear (64T/41T) (Not Spared)
16	-	Gear (28T) (Not Spared)
17	-	Gear (Not Spared)
18	-	Gear (Not Spared)
19	-	Link (Not Spared)
20	-	Pulley (25T) (Not Spared)
21	-	Exit Shaft (Not Spared)
22	-	Spring (Not Spared)
23	-	Spring (Not Spared)
24	-	Spring (Not Spared)
25	-	Coupling (Not Spared)
26	-	Pin Dowel (Not Spared)
27	-	Stud (Not Spared)
28	-	Label (Not Spared)
29	-	Wire Harness (Not Spared)
30	413W11660	Bearing
31	-	Spring (Not Spared)

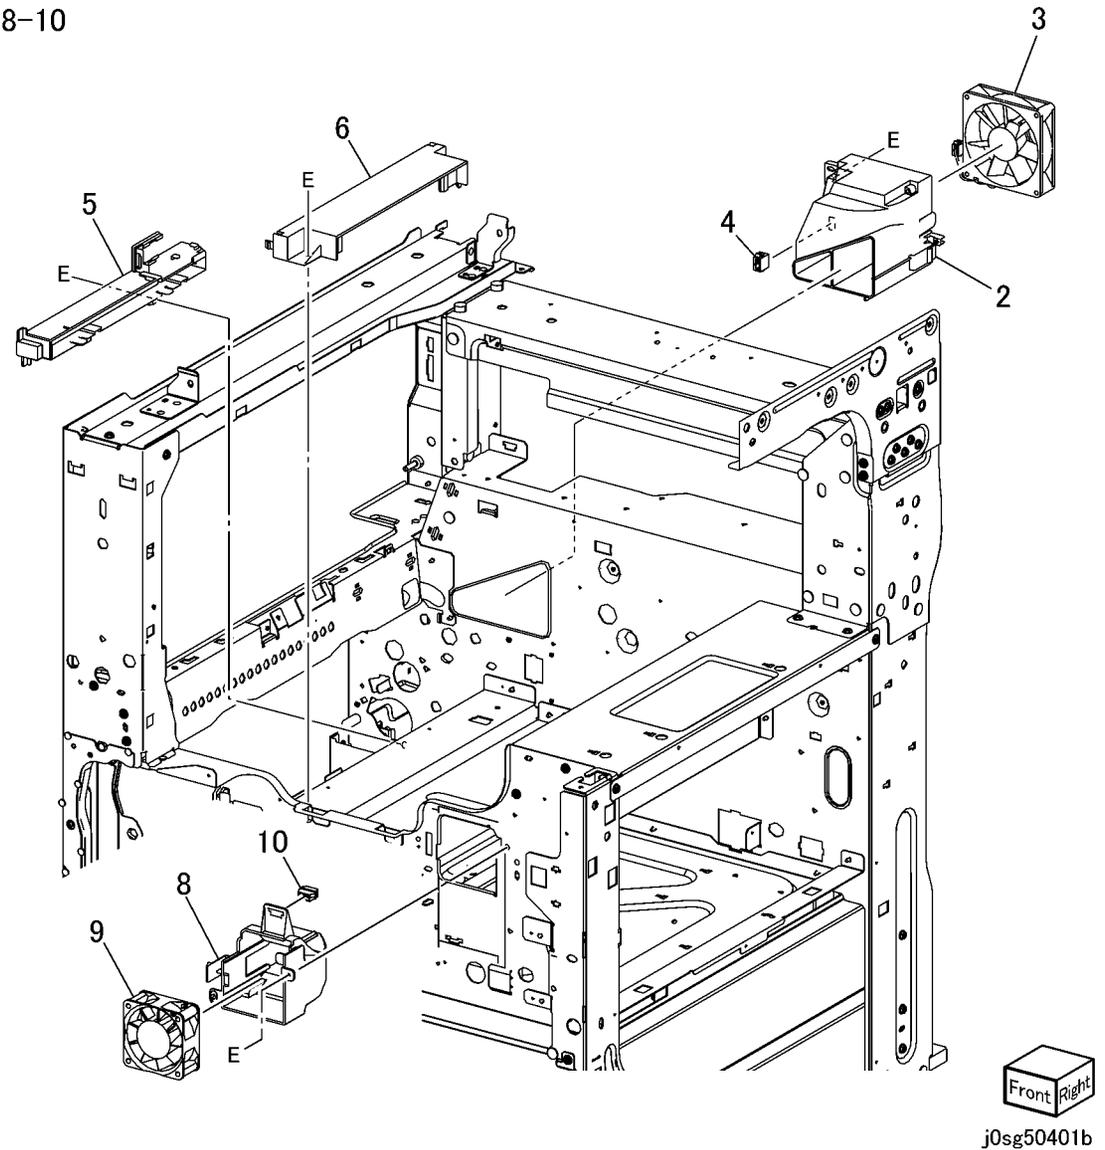
PL 4.1 NOHAD

Item	Part	Description
1	054K45710	Fuser Duct Assembly (Includes Items 2-4)
2	-	Fuser Duct (P/O PL 4.1 Item 1)
3	-	Fuser Fan (P/O PL 4.1 Item 1)
4	-	Connector (P/O PL 4.1 Item 1)
5	-	ROS Housing Duct (Not Spared)
6	-	ROS Housing Cover (Not Spared)
7	054K45720	ROS Duct Assembly (Includes Items 8-10)
8	-	ROS Duct (P/O PL 4.1 Item 7)
9	-	Fan (Not Spared)
10	-	CRU Connector (P/O PL 4.1 Item 7)

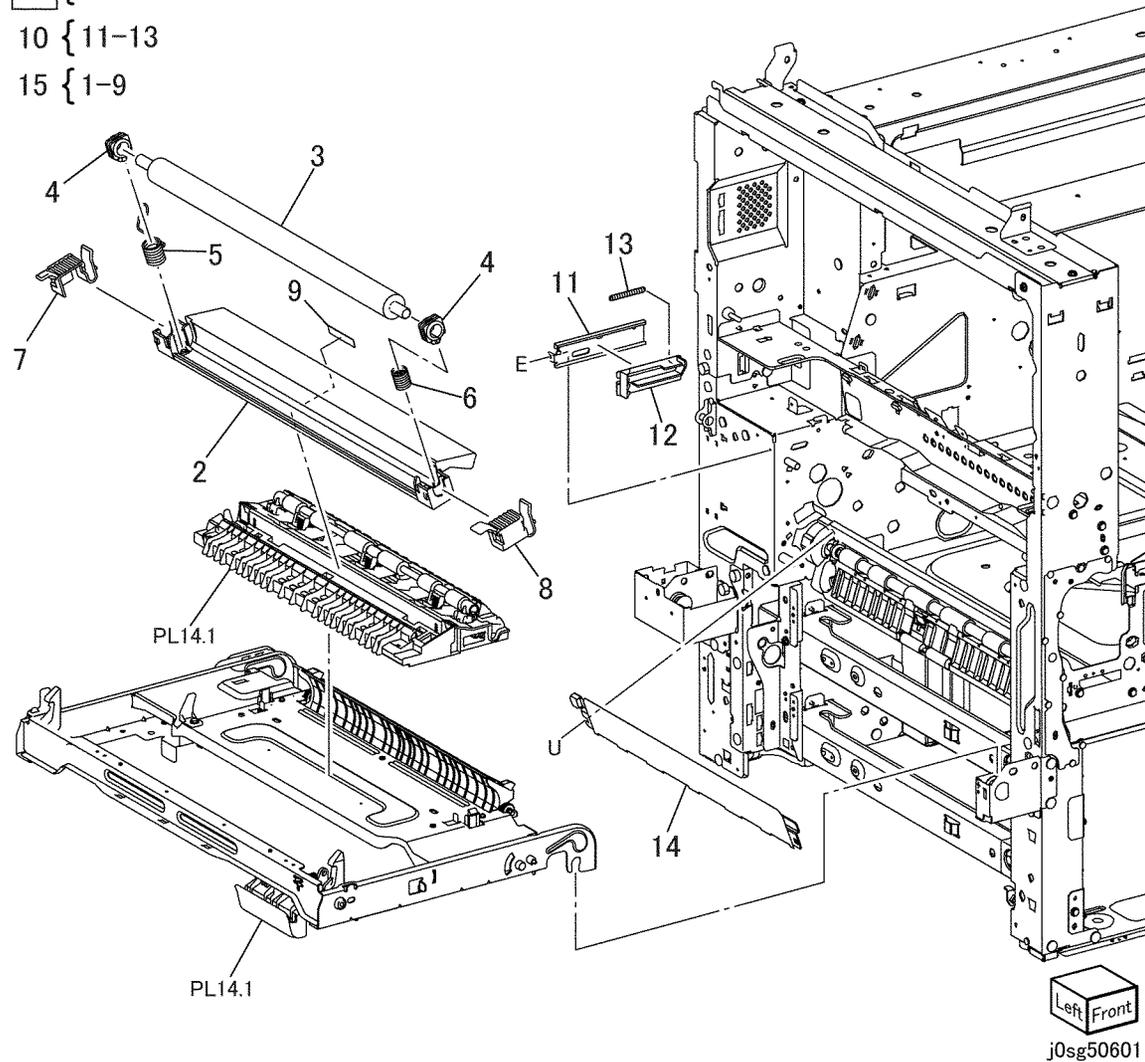
PL 6.1 Transfer

Item	Part	Description
1	–	BTR Assembly (Not Spared) (Includes Items 2-6)
2	–	BTR Housing (Not Spared)
3	–	BiasTransfer Roll (BTR) (Not Spared)
4	–	Bearing (Not Spared)
5	–	Spring (Not Spared)
6	–	Spring (Not Spared)
7	–	Rear Lever (Not Spared)
8	–	Front Lever (Not Spared)
9	–	Label (P/O PL 6.1 Item 15)
10	012K94341	Shutter Link Assembly (Includes Items 11-13)
11	–	Shutter Rod (P/O PL 6.1 Item 10)
12	–	Housing (P/O PL 6.1 Item 10)
13	–	Spring (P/O PL 6.1 Item 10)
14	054K47100	Chute
15	802K81270	BTR Housing Assembly (Includes Items 1-9)

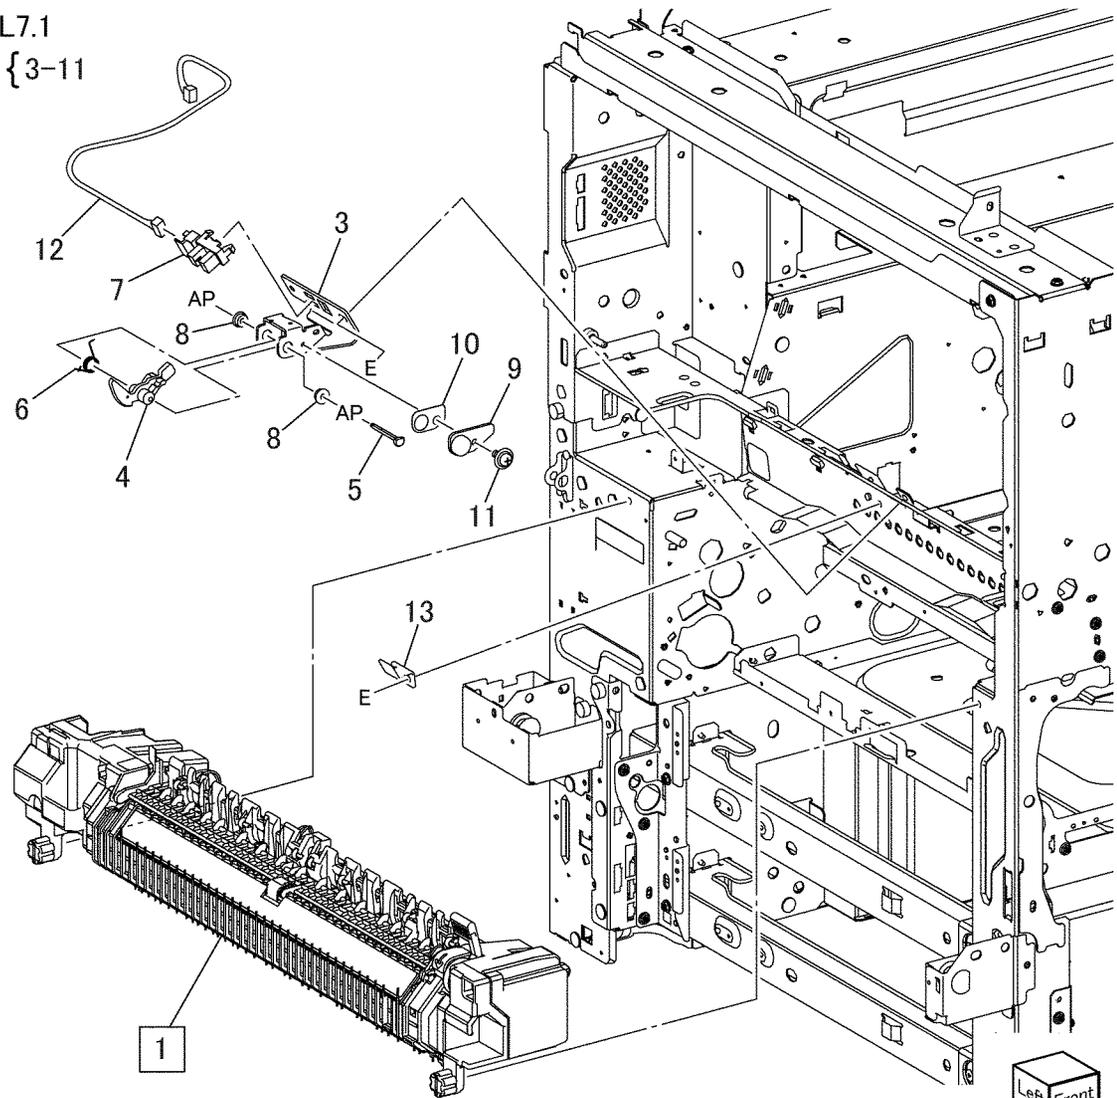
PL 7.1 Fusing

Item	Part	Description
1	126K29392	Fuser (120V) (REP 10.3)
-	126K29403	Fuser (220V) (REP 10.3)
2	815K02550	Exit Sensor Plate Assembly (Includes Items 3-11) (REP 10.4)
3	-	Exit Sensor Bracket (P/O PL 7.1 Item 2)
4	-	Actuator (P/O PL 7.1 Item 2)
5	-	Shaft (P/O PL 7.1 Item 2)
6	-	Spring (P/O PL 7.1 Item 2)
7	-	Fuser Exit Sensor (P/O PL 7.1 Item 2)
8	-	Bearing (P/O PL 7.1 Item 2)
9	-	Actuator Stopper (P/O PL 7.1 Item 2)
10	-	Stopper Tape (P/O PL 7.1 Item 2)
11	-	Screw (P/O PL 7.1 Item 2)
12	-	Wire Harness (Not Spared)
13	-	Plate (Not Spared)
