WorkCentre 5335 Family Service Documentation

705P01303

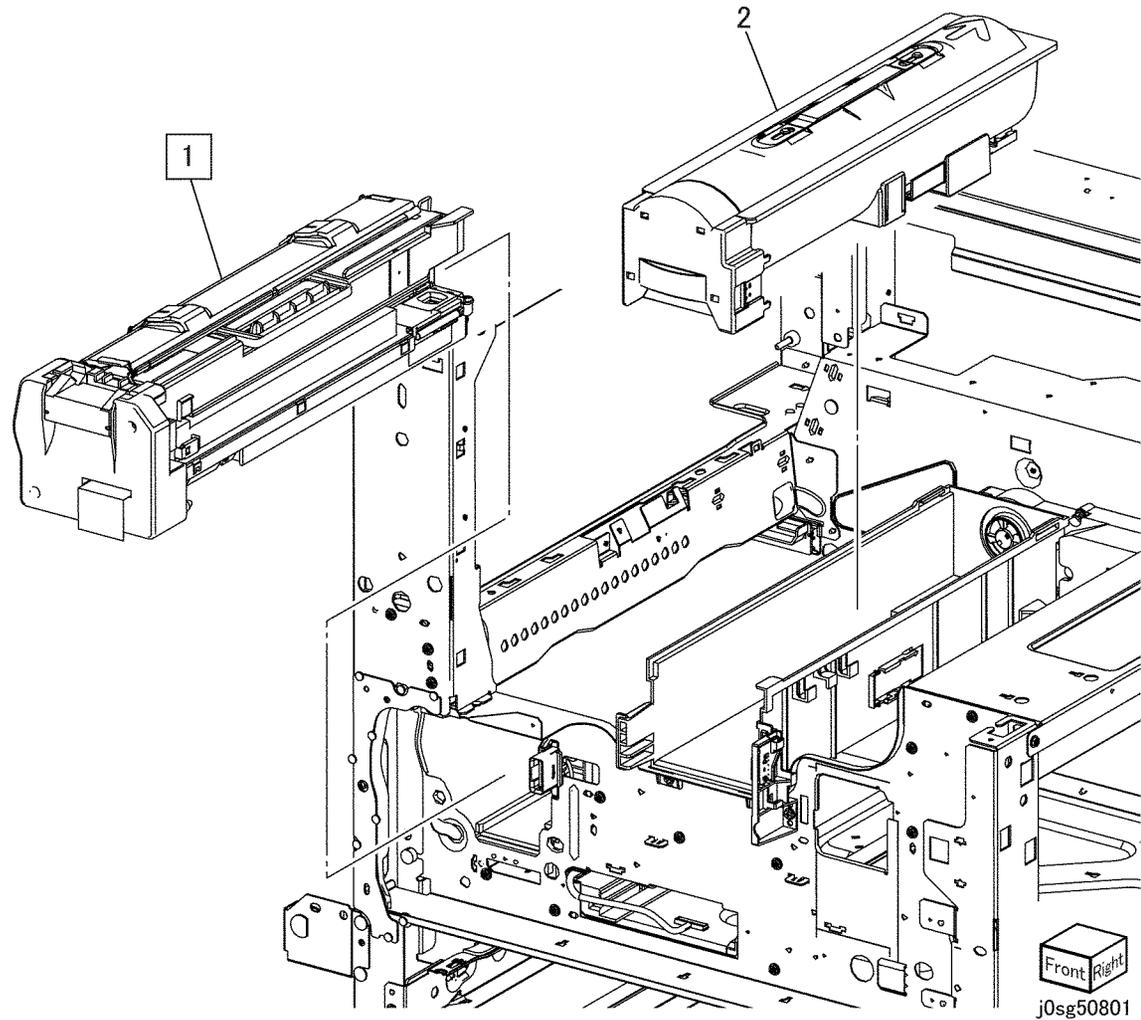
PL 8.1 CRU, Toner Cartridge

Item	Part	Description
1	013R00591	Xerographic (Drum) Cartridge
2	006R01158	Toner Cartridge(WW - Metered)
-	006R01159	Toner Cartridge (NA/ESG - Sold)
-	006R01160	Toner Cartridge (DMO - Sold)

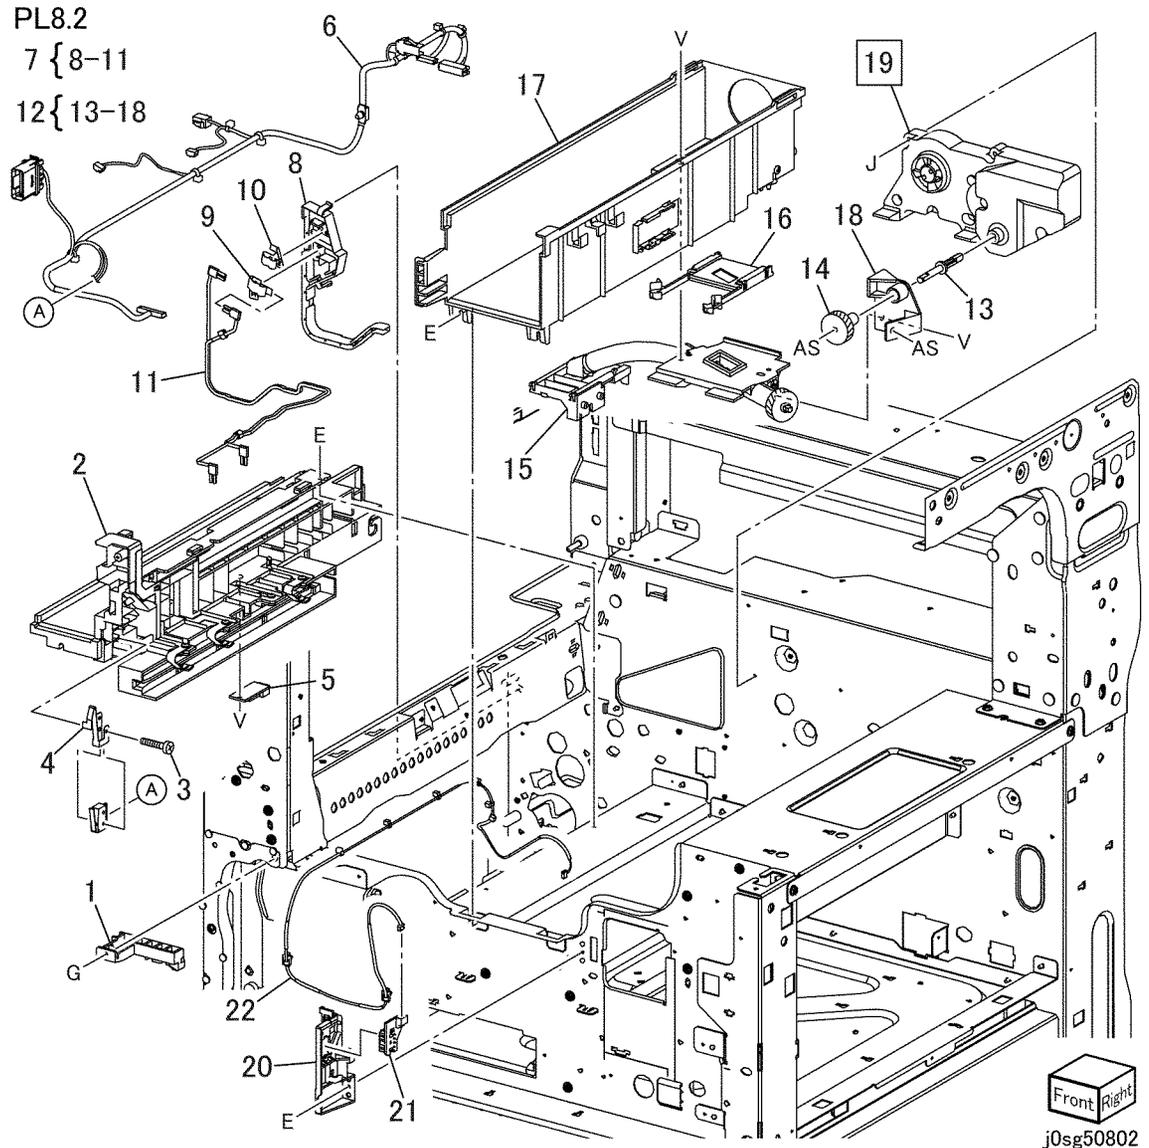
PL 8.2 Toner System

Item	Part	Description
1	-	CRU Stopper (Not Spared)
2	-	Xero Cartridge Guide Assembly (Not Spared) (REP 9.1)
3	-	Screw (Not Spared)
4	-	Plate (Not Spared)
5	930W00803	Hum And Temp Sensor (REP 9.3)
6	962K90031	Xerographic Wire Harness (Includes the Interlock Switch) (REP 9.2)
7	-	Contact Cover Assembly (Not Spared) (Includes Items 8-11)
8	-	Contact Cover (P/O PL 8.2 Item 7)
9	-	Contact Spring (P/O PL 8.2 Item 7)
10	-	Contact Spring (P/O PL 8.2 Item 7)
11	-	Harness (Not Spared)
12	032K96941	Cartridge Guide Assembly (Includes Items 13-18)
13	-	Drive Shaft (Not Spared)
14	-	Gear 13T (Not Spared)
15	-	Dispenser (Not Spared)
16	-	Cartridge Stopper (Not Spared)
17	-	Toner Cartridge Guide (Not Spared) (REP 9.5)
18	-	Dispenser Support (Not Spared)
19	127K38040	Dispense Motor (REP 9.6)
20	-	PWB Bracket (Not Spared)
21	604K68220	CRUM PWB
22	-	Wire Harness (Not Spared)

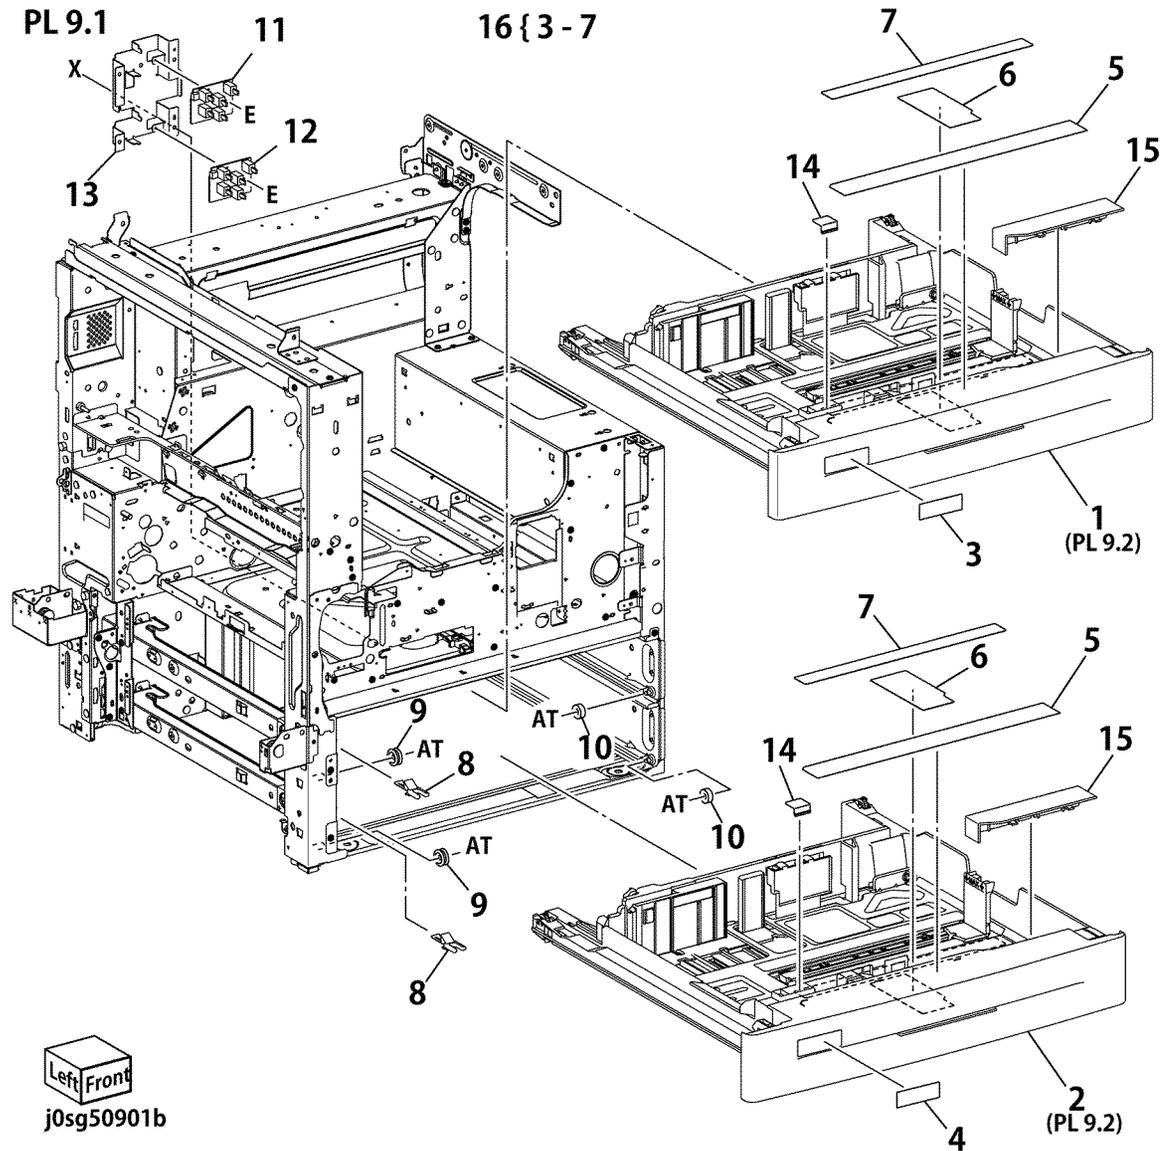
PL 9.1 Tray 1/2 Assembly

Item	Part	Description
1	050K65076	Tray 1 Assembly (REF: PL 9.2) (REP 7.1)
2	-	Tray 2 Assembly (REF: PL 9.2) (Same PN as Item 1) (REP 7.1)
3	-	No.1 Label (P/O PL 9.1 Item 16)
4	-	No.2 Label (P/O PL 9.1 Item 16)
5	-	Instruction Label (P/O PL 9.1 Item 16)
6	-	Side Size Label (P/O PL 9.1 Item 16)
7	-	End Size Label (P/O PL 9.1 Item 16)
8	003E75431	Stopper
9	059E03500	Roller
10	059E03510	Roller
11	110K12100	Tray 1 Size Switch
12	-	Tray 2 Size Switch (Same PN as Item 11)
13	-	Switch Bracket (Not Spared)
14	014E45291	Slide Lock Block
15	848E21141	Rail Cover
16	604K68210	Label Kit (Includes Item 3-7)

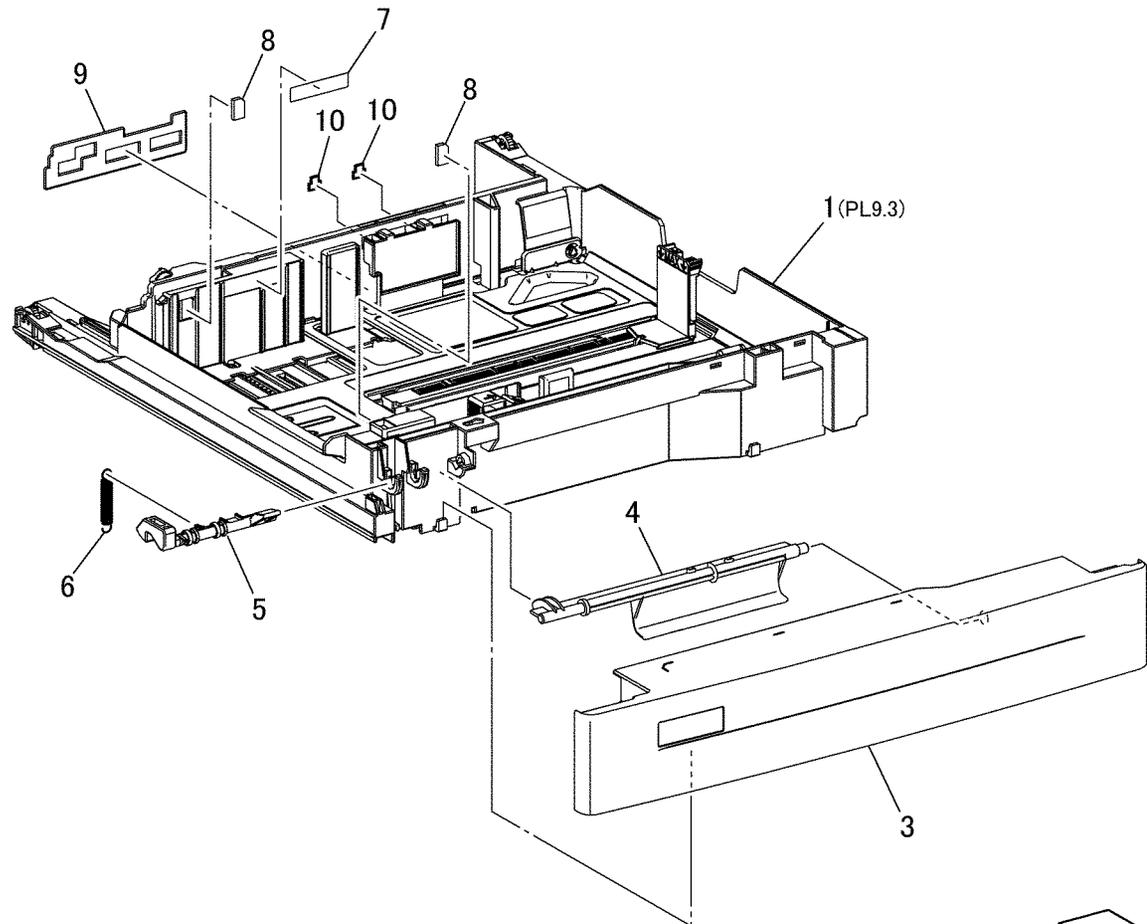
PL 9.2 Tray 1/2 (1 of 2)

Item	Part	Description
1	-	Tray 1/2 Assembly (REF: PL 9.3)
2	848K40411	Tray 1/2 Front Cover Assembly (Includes Items 3, 4)
3	-	Tray 1/2 Front Cover (Not Spared)
4	-	Handle Lever (Not Spared)
5	003E75440	Latch
6	809E75730	Spring
7	-	Max Label (P/O PL 9.1 Item 16)
8	019E71680	Pad
9	-	End Spacer (Not Spared)
10	-	Side Spacer (Not Spared)

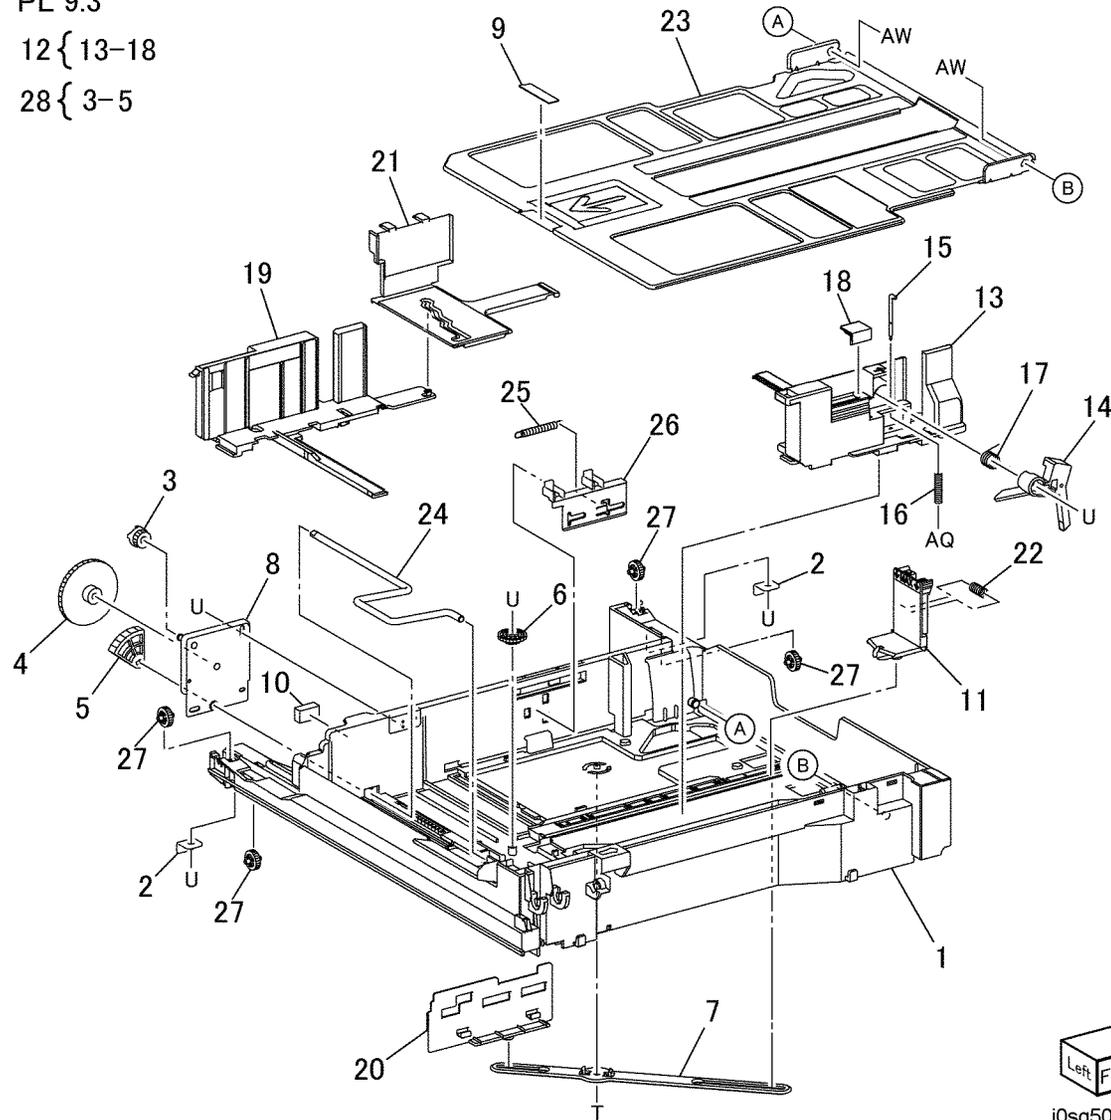
PL 9.3 Tray 1/2 (2 of 2)

Item	Part	Description
1	-	Housing Cassette (Not Spared)
2	-	Tray Stopper (Not Spared)
3	-	Gear (13T) (P/O PL 9.3 Item 28)
4	-	Gear (13T/60T) (P/O PL 9.3 Item 28)
5	-	Gear (60T) (P/O PL 9.3 Item 28)
6	807E13521	Pinion
7	-	End Guide Link (Not Spared)
8	-	Rear Plate (Not Spared)
9	019K09580	Bottom Pad
10	-	Gasket (Not Spared)
11	038E26533	End Guide
12	038K89450	Front Guide Assembly (Includes Items 13-18)
13	-	Front Guide (P/O PL 9.3 Item 12)
14	-	Knob (P/O PL 9.3 Item 12)
15	-	Pin (P/O PL 9.3 Item 12)
16	-	Spring (P/O PL 9.3 Item 12)
17	-	Spring (P/O PL 9.3 Item 12)
18	010E93341	Lock Slide
19	038E39090	Side Guide
20	-	End Guide Actuator (Not Spared)
21	-	Side Actuator (Not Spared)
22	-	Spring (Not Spared)
23	-	Bottom Plate (Not Spared)
24	-	Lift Shaft (Not Spared)
25	-	Spring (Not Spared)
26	-	Side Actuator (Not Spared)
27	059E03522	Rear Roller
28	604K20541	Gear Kit (Includes Items 3-5)

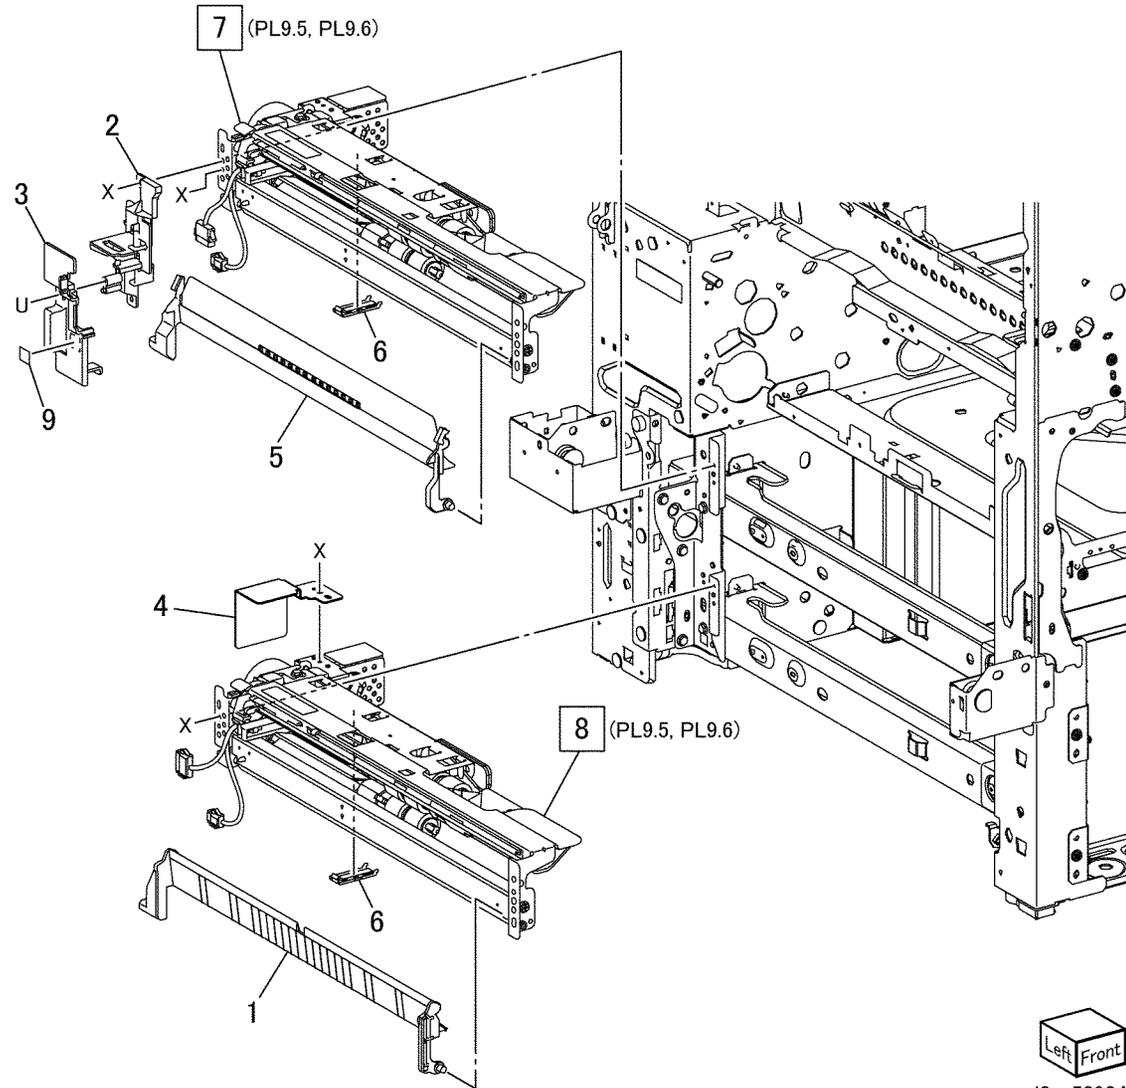
PL 9.4 Tray Feeder 1/2 Assembly

Item	Part	Description
1	054E33802	Feed Out Chute
2	-	Harness Holder (Not Spared)
3	-	Harness Cover (Not Spared)
4	-	Bracket (Not Spared)
5	054K45941	Feeder Chute
6	-	Sensor Cover (Not Spared)
7	059K71251	Tray 1 Feeder Assembly (REF: PL 9.5, PL 9.6) (REP 8.1)
8	-	Tray 2 Feeder Assembly (Same PN as Item 7) (REP 8.2)
9	-	BP Label (Not Spared)

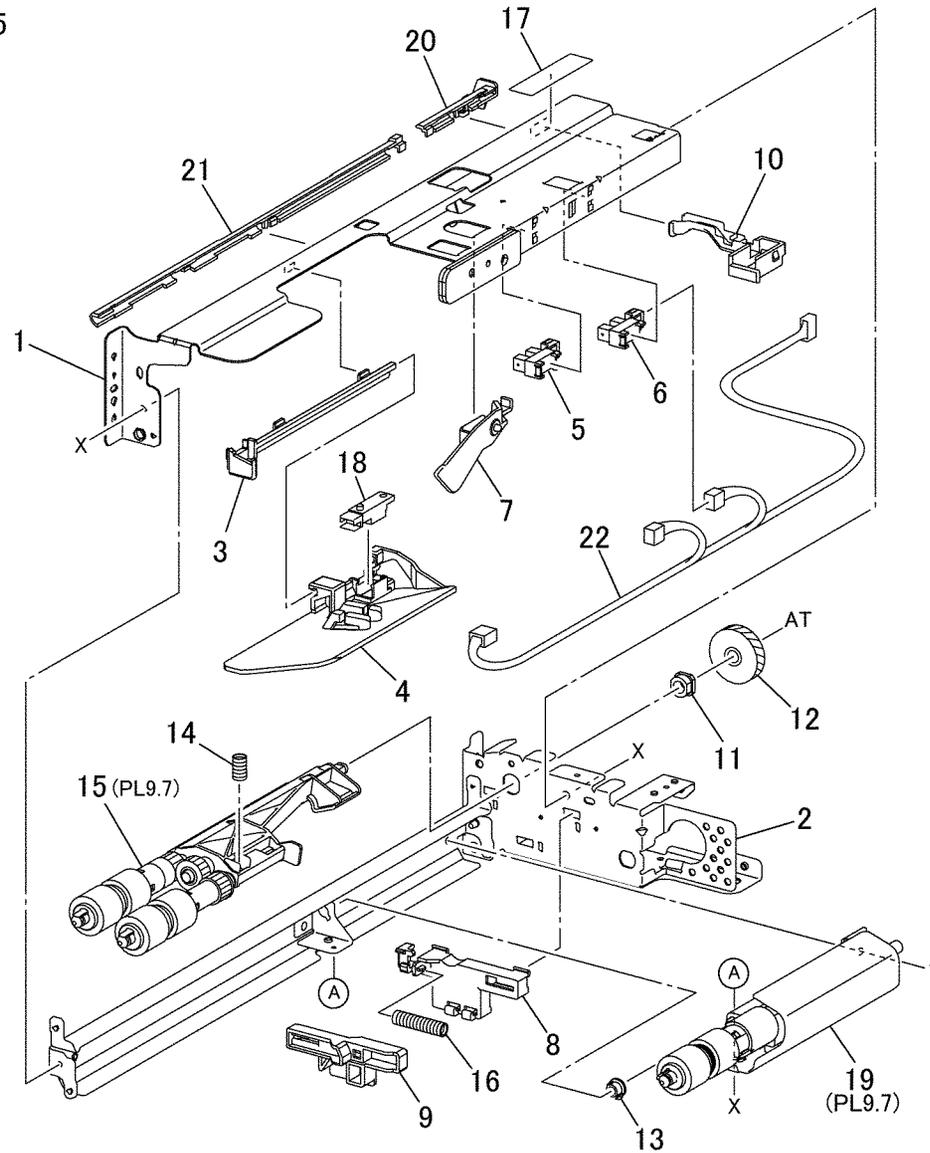
PL 9.5 Feeder 1/2 Assembly (1 of 2)

Item	Part	Description
1	-	Upper Frame (Not Spared)
2	-	Lower Frame (Not Spared)
3	-	Rail (Not Spared)
4	-	Chute (Not Spared)
5	930W00113	Tray 1/2 No Paper Sensor
6	-	Tray 1/2 Level Sensor (Same PN as Item 5)
7	120E22481	Actuator
8	-	Holder (Not Spared)
9	-	Lever (Not Spared)
10	-	Holder Harness (Not Spared)
11	413W11660	Bearing
12	-	Gear (30T) (Not Spared)
13	-	Bearing (Not Spared)
14	-	Spring (Not Spared)
15	-	Feed Roll/Nudger Roll Assembly (REF: PL 9.7)
16	-	Spring (Not Spared)
17	-	Traceability Label (Not Spared)
18	930W00211	Tray 1/2 Prefeed Sensor
19	-	Retard Roll Assembly (REF: PL 9.7)
20	-	Rear Harness Holder (Not Spared)
21	-	Center Harness Holder (Not Spared)
22	-	Wire Harness (Not Spared)

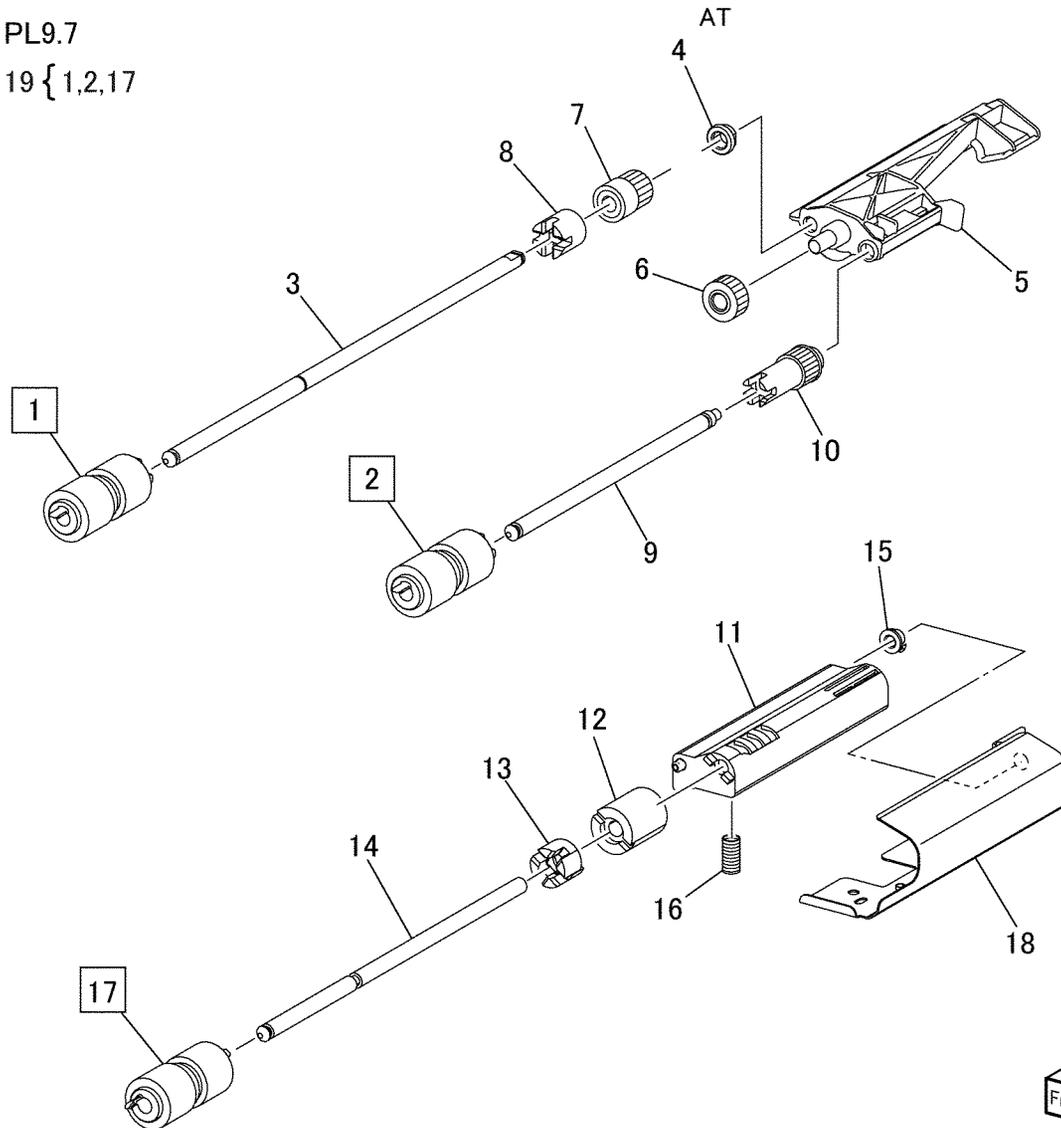
PL 9.7 Tray 1/2 Feed Roll, Nudger Roll, Retard Roll

Item	Part	Description
1	-	Feed Roll (P/O PL 9.7 Item 19) (REP 8.5)
2	-	Nudger Roll (P/O PL 9.7 Item 19) (REP 8.5)
3	-	Feed Shaft (Not Spared)
4	-	Bearing (Not Spared)
5	-	Nudger Support (Not Spared)
6	007E79380	Gear (33T)
7	005K06760	Clutch Assembly (22T)
8	005K05890	Oneway Clutch
9	-	Nudger Shaft (Not Spared)
10	-	Gear (25T) (Not Spared)
11	-	Retard Support (Not Spared)
12	005K09290	Friction Clutch
13	-	Spacer (Not Spared)
14	-	Retard Shaft (Not Spared)
15	-	Bearing (Not Spared)
16	-	Spring (Not Spared)
17	-	Retard Roll (P/O PL 9.7 Item 19) (REP 8.5)
18	-	Feed In Chute (Not Spared)
19	604K56080	FeedRoll/Nudger Roll/Retard Roll Kit (Includes Items 1, 2, 17) (REP 8.5)

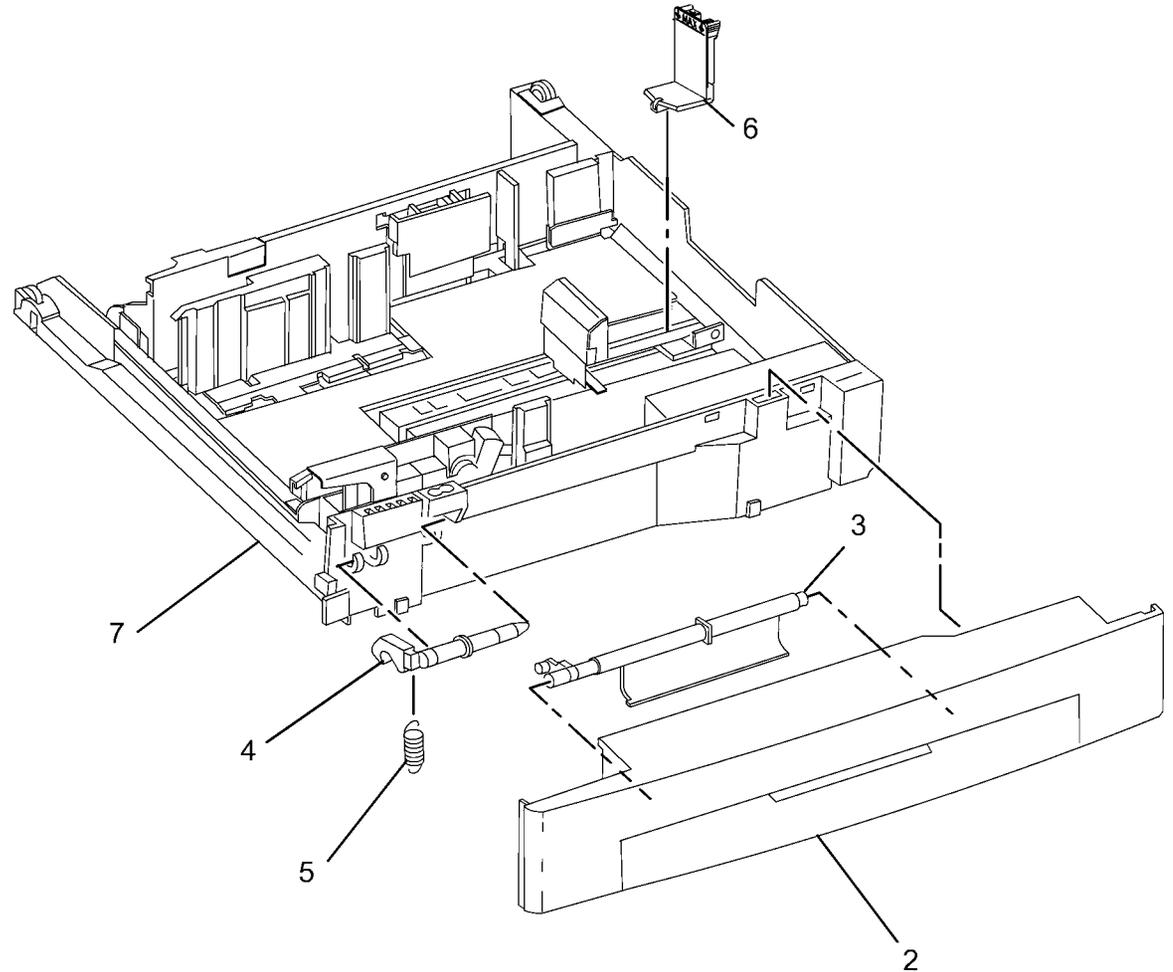
PL 9.8 Envelope Tray Assembly

Item	Part	Description
1	604K70020	Envelope Tray Assembly
2	—	Front Cover (P/O PL 9.8 Item 1)
3	—	Lever (P/O PL 9.8 Item 1)
4	003E75440	Latch
5	809E75730	Spring
6	038E26533	End Guide
7	—	Envelope Tray Frame (P/O PL 9.8 Item 1)

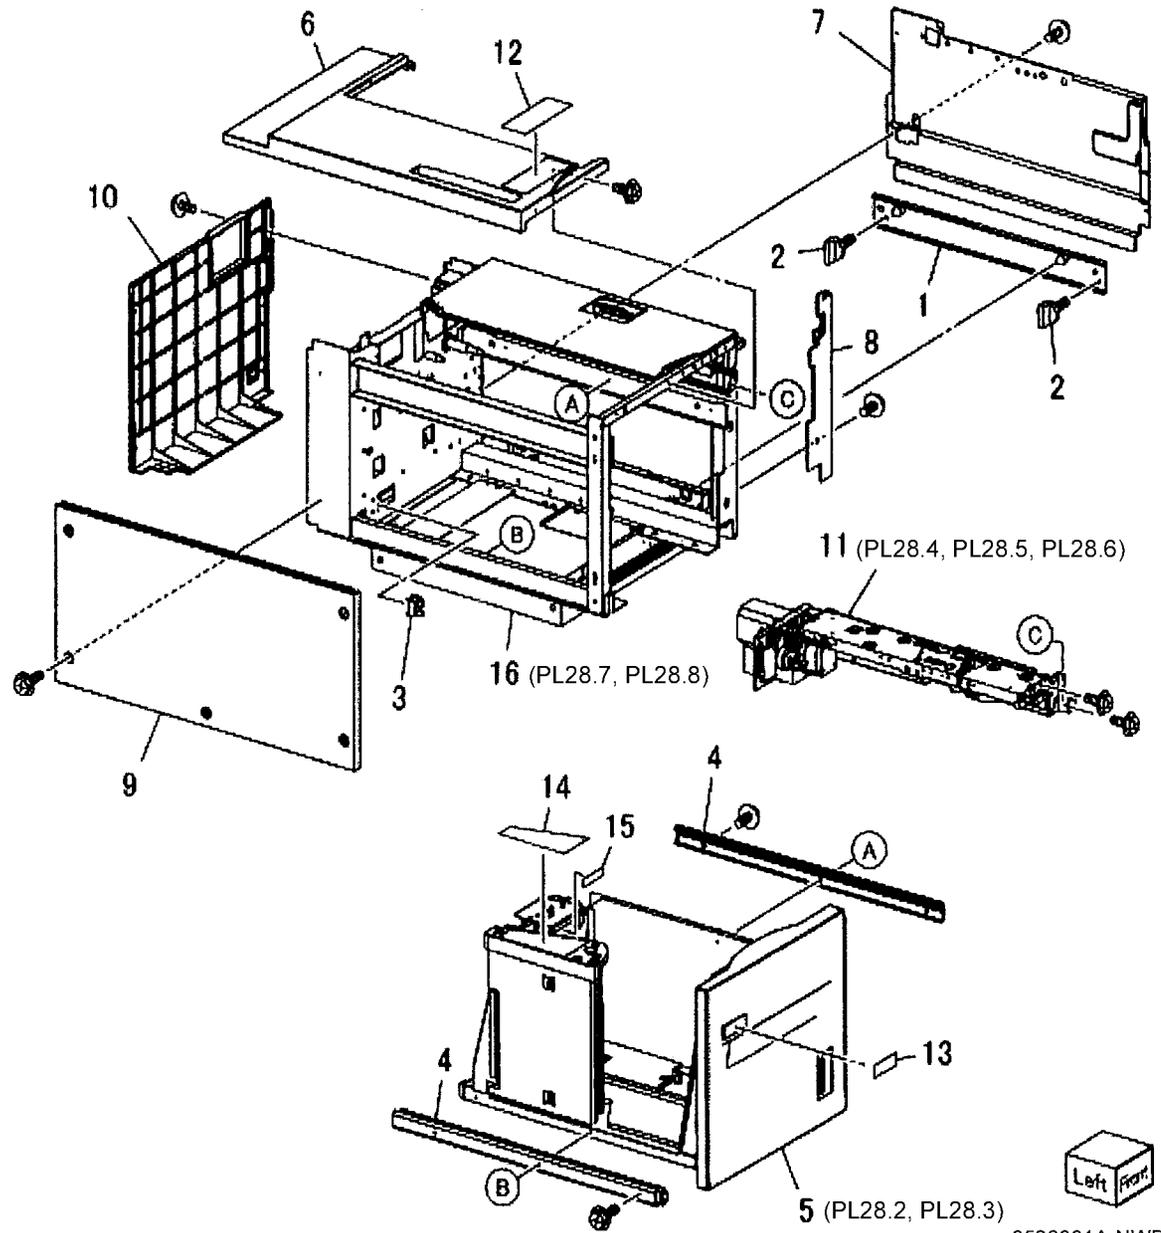
PL 10.1 HCF Unit

Item	Part	Description
1	-	Joint Plate (Not Spared)
2	003K91881	Knob
3	130K55590	HCF Tray Set Sensor
4	801K15700	Tray Rail
5	-	HCF Tray 6 (REP 19.1)
6	-	Left Top Cover (Not Spared)
7	-	Right Cover (Not Spared)
8	-	Front Right Cover (Not Spared)
9	-	Left Cover (Not Spared)
10	-	Rear Cover (Not Spared)
11	-	HCF Feeder (Not Spared) (REP 19.2)
12	-	Label (Top) (Not Spared)
13	-	Label (Tray Number) (Not Spared)
14	-	Label (Size) (Not Spared)
15	-	Label (End) (Not Spared)
16	-	Frame Assembly (Not Spared)

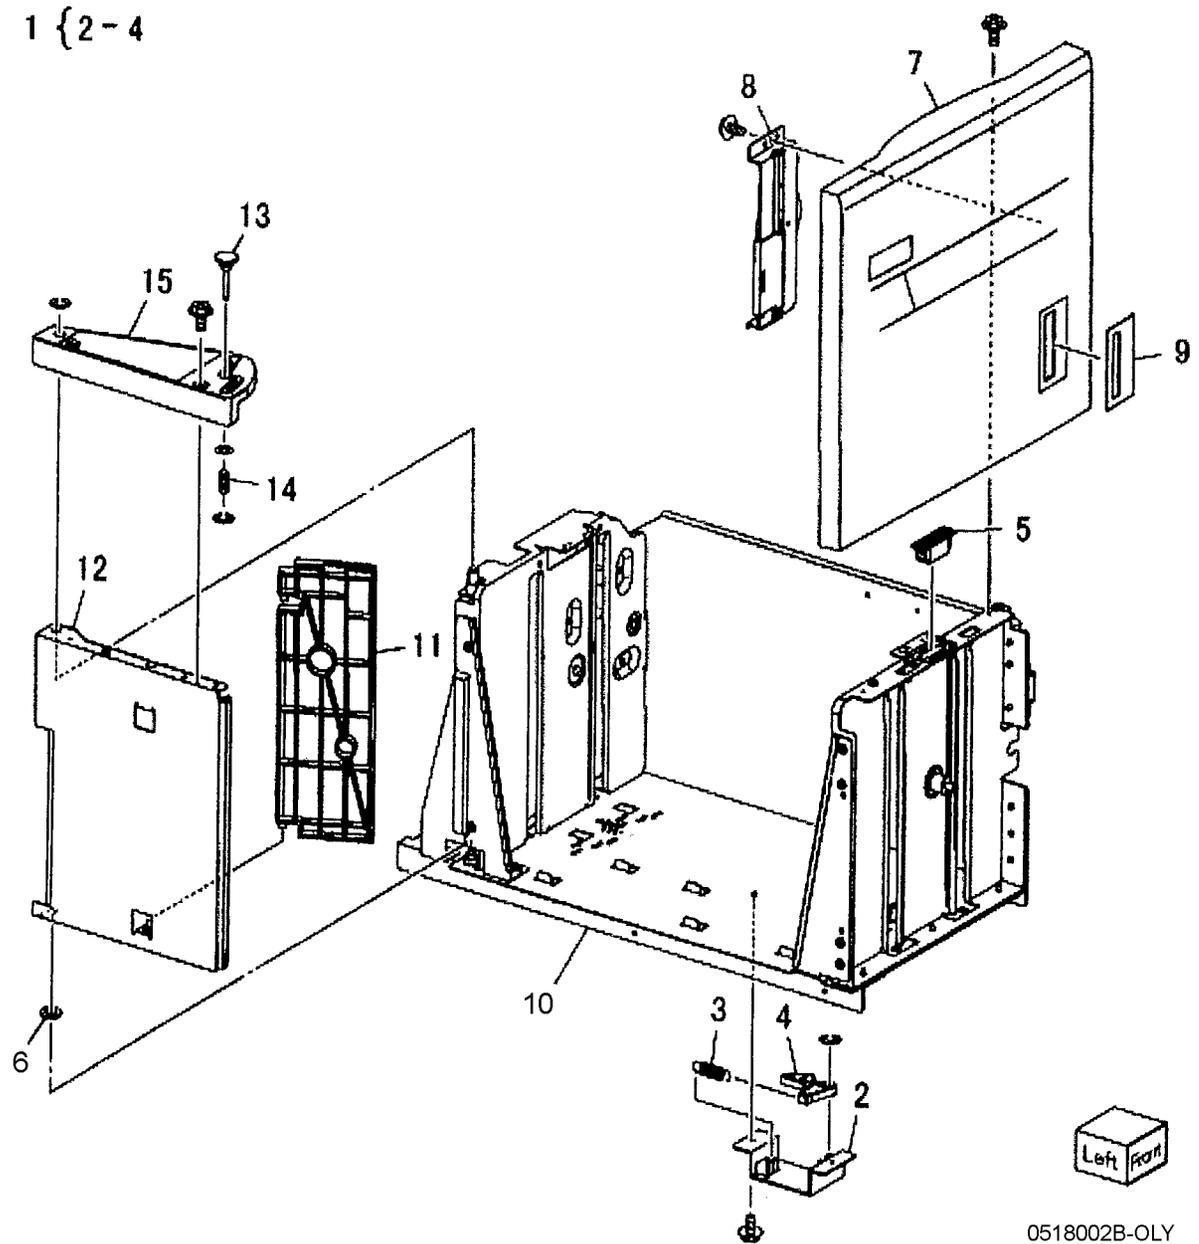
PL 10.2 HCF Tray 6 (1 of 2)

Item	Part	Description
1	-	Tray Latch Assembly (Not Spared)
2	003K13592	Tray Latch
3	-	Spring (P/O PL 10.2 Item 1)
4	-	Latch Lever (P/O PL 10.2 Item 1)
5	-	Magnet (P/O PL 10.1 Item 5)
6	-	Wave Washer (P/O PL 10.1 Item 5)
7	-	Front Cover (P/O PL 10.1 Item 5)
8	-	Gear Bracket (P/O PL 10.1 Item 5)
9	-	Label (Gauge) (P/O PL 10.1 Item 5)
10	-	Frame (P/O PL 10.1 Item 5)
11	-	Plate (P/O PL 10.1 Item 5)
12	-	Bracket (P/O PL 10.1 Item 5)
13	-	Pin (P/O PL 10.1 Item 5)
14	-	Spring (P/O PL 10.1 Item 5)
15	-	Top Plate (P/O PL 10.1 Item 5)

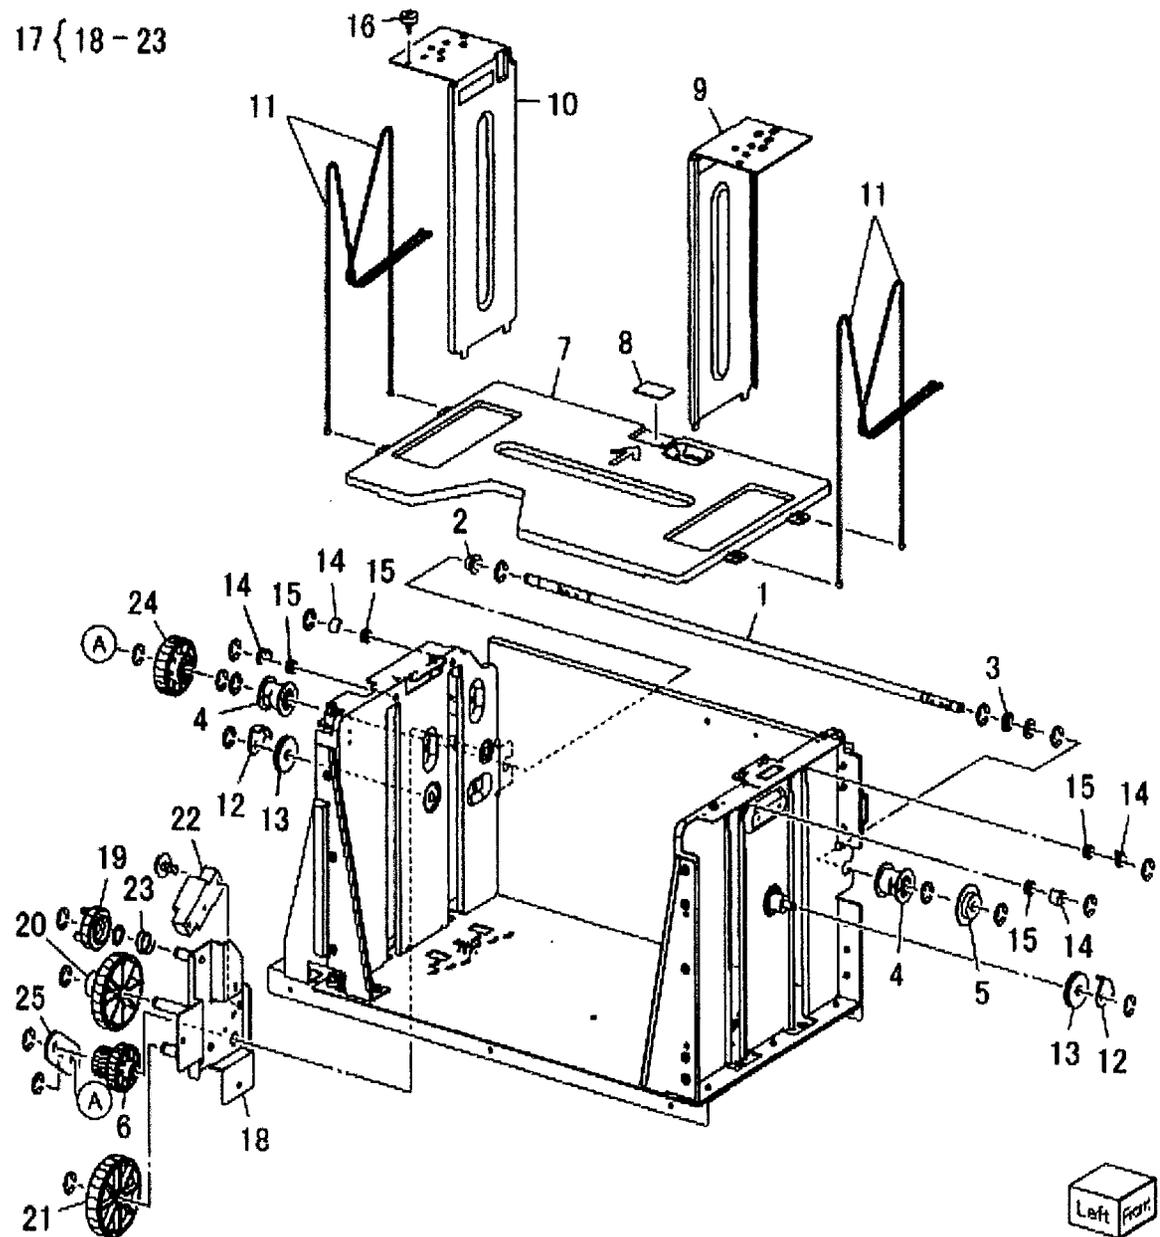
PL 10.3 HCF Tray 6 (2 of 2)

Item	Part	Description
1	-	Lift Shaft (P/O PL 10.1 Item 5)
2	-	Bearing (P/O PL 10.1 Item 5)
3	-	Bearing (P/O PL 10.1 Item 5)
4	020E37620	Tray Cable Pulley
5	-	Gear (P/O PL 10.1 Item 5)
6	-	Gear (P/O PL 10.1 Item 5)
7	-	Bottom Plate (P/O PL 10.1 Item 5)
8	019E58620	Pad
9	-	Front Side Guide (P/O PL 10.1 Item 5)
10	-	Rear Side Guide (P/O PL 10.1 Item 5)
11	604K19981	Cable And Pulley Kit (REP 19.4)
12	032E22410	Wire Guide (L)
13	-	Pulley (P/O PL 10.1 Item 5)
14	-	Wire Guide (S) (P/O PL 10.1 Item 5)
15	-	Pulley (P/O PL 10.1 Item 5)
16	-	Screw (P/O PL 10.1 Item 5)
17	015K65532	Gear Bracket Assembly
18	-	Gear Bracket (P/O PL 10.3 Item 17)
19	-	Contact Gear (P/O PL 10.3 Item 17)
20	-	Gear (P/O PL 10.3 Item 17)
21	-	Gear (P/O PL 10.3 Item 17)
22	-	Brake (P/O PL 10.3 Item 17)
23	-	Spring (P/O PL 10.3 Item 17)
24	807E04500	Lift Gear
25	-	Plate (P/O PL 10.1 Item 5)

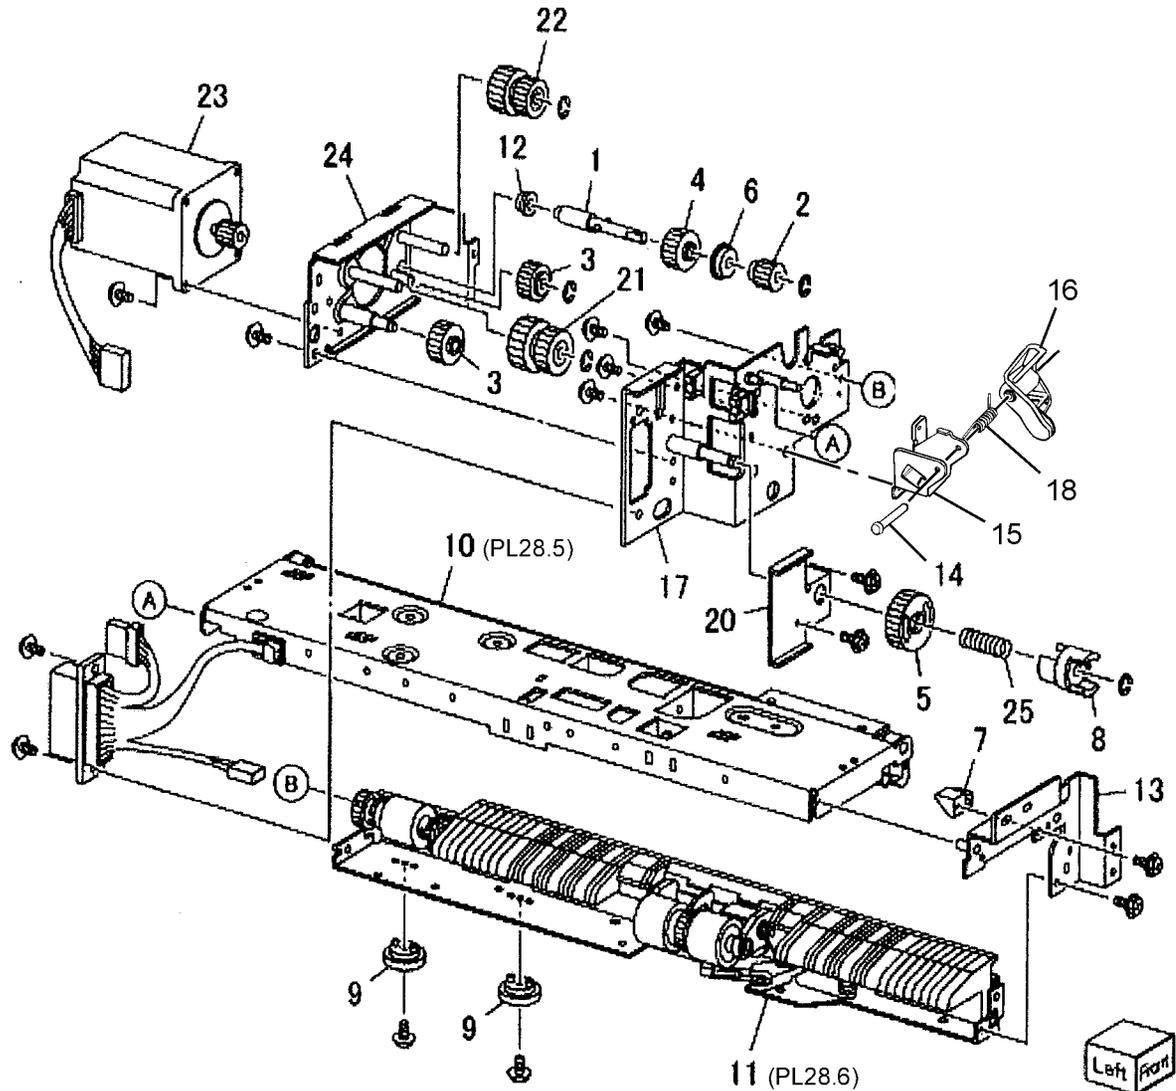
PL 10.4 HCF Feeder (1 of 3)

Item	Part	Description
1	-	Shaft (P/O PL 10.1 Item 11)
2	007E78760	Gear (19T)
3	-	Gear (25T) (P/O PL 10.1 Item 11)
4	007E78780	Gear (25T)
5	007E78790	Gear (40T)
6	013E25530	Bearing
7	-	Block (P/O PL 10.1 Item 11)
8	-	Spacer (P/O PL 10.1 Item 11)
9	019E56470	Holder
10	-	Upper Feeder Assembly (P/O PL 10.1 Item 11)
11	-	Lower Feeder Assembly (P/O PL 10.1 Item 11)
12	-	Ball Bearing (P/O PL 10.1 Item 11)
13	-	Front Frame (P/O PL 10.1 Item 11)
14	-	Pin (P/O PL 10.1 Item 11)
15	-	Down Bracket (P/O PL 10.1 Item 11)
16	-	Link Bracket (P/O PL 10.1 Item 11)
17	-	Rear Frame (P/O PL 10.1 Item 11)
18	-	Tension Spring (P/O PL 10.1 Item 11)
19	-	Lift/Motor Frame (P/O PL 10.1 Item 11)
20	-	Bracket (P/O PL 10.4 Item 19)
21	007K88520	Gear (23T/27T)
22	007K88530	Gear (31T/36T)
23	127K37901	Lift/Feed Motor (REP 19.12)
24	-	Plate (P/O PL 10.4 Item 19)
25	-	Spring (P/O PL 10.1 Item 11)

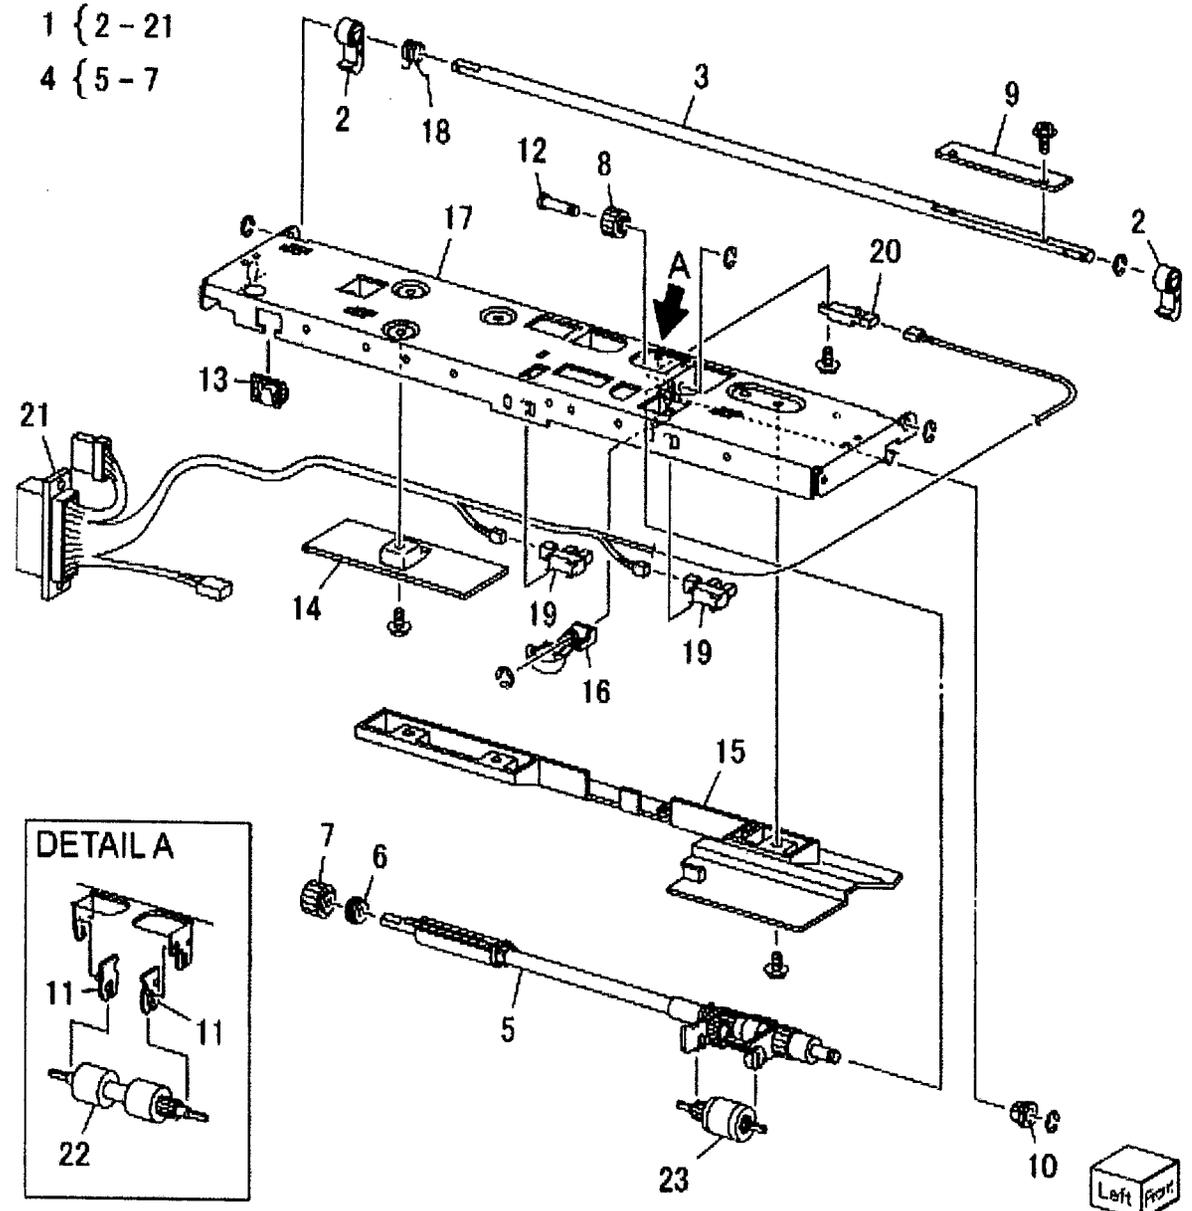
PL 10.5 HCF Feeder (2 of 3)

Item	Part	Description
1	-	Upper Feeder Assembly (P/O PL 10.1 Item 11)
2	003E59570	Latch
3	-	Shaft Latch (P/O PL 10.5 Item 1)
4	006K23124	Feed Shaft Assembly
5	-	Feed Shaft (P/O PL 10.5 Item 4)
6	-	Ball Bearing (P/O PL 10.5 Item 4)
7	-	Gear (20T) (P/O PL 10.5 Item 4)
8	007E78180	Feed Gear (25T)
9	-	Lever (P/O PL 10.5 Item 1)
10	-	Bearing (P/O PL 10.5 Item 1)
11	-	Spacer (P/O PL 10.5 Item 1)
12	-	Pin Drive (P/O PL 10.5 Item 1)
13	-	Guide (P/O PL 10.5 Item 1)
14	-	Rear Upper Chute (P/O PL 10.5 Item 1)
15	-	Upper Chute (P/O PL 10.5 Item 1)
16	120E21900	Actuator
17	-	Upper Frame (P/O PL 10.5 Item 1)
18	-	Spring (P/O PL 10.5 Item 1)
19	-	HCF Stack Height Sensor, HCF Paper Sensor (P/O PL 10.5 Item 1)
20	-	HCF Pre Feed Sensor (P/O PL 10.5 Item 1)
21	-	Wire Harness (P/O PL 10.5 Item 1)
22	059K26691	Feed Roll (REP 19.5)
23	059K26702	Nudger Roll (REP 19.5)

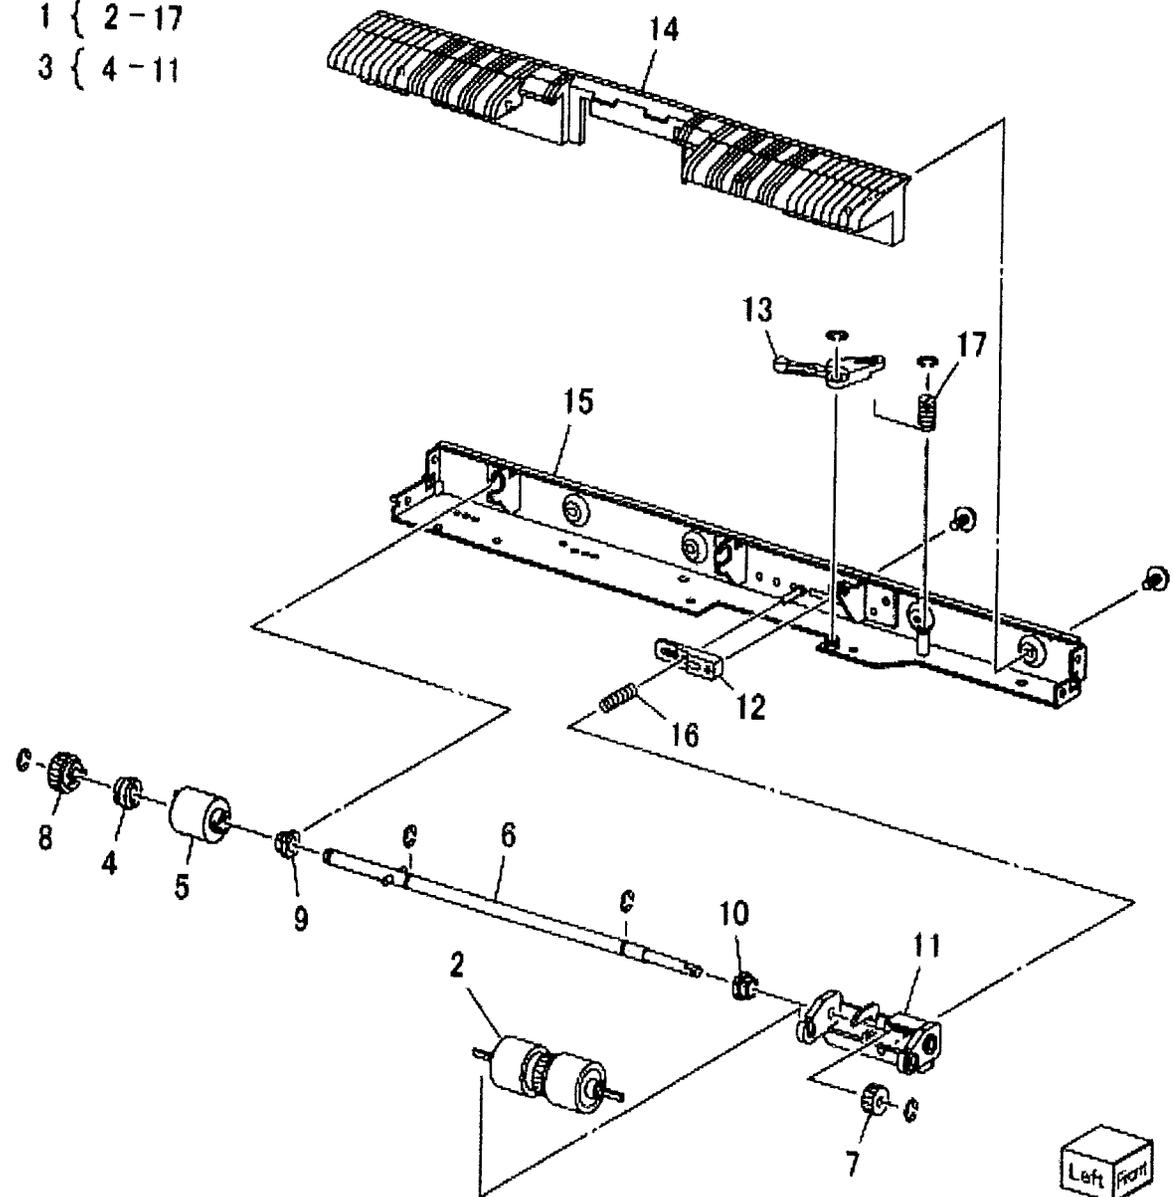
Item	Part	Description
1	059K26591	Lower Feed Assembly
2	-	Retard Roll Assembly (P/O PL 10.6 Item 1) (REP 19.5)
3	-	Retard Shaft Assembly (P/O PL 10.6 Item 1)
4	-	Collar (P/O PL 10.6 Item 3)
5	005K06701	Friction Clutch
6	-	Shaft (P/O PL 10.6 Item 3)
7	007E78170	Gear (15T)
8	007E89760	Gear (22T)
9	013E23600	Bearing
10	013E23610	Bearing
11	-	Retard Bracket (P/O PL 10.6 Item 1)
12	-	Slide (P/O PL 10.6 Item 1)
13	-	Lever (P/O PL 10.6 Item 1)
14	-	Lower Chute (P/O PL 10.6 Item 1)
15	-	Lower Frame (P/O PL 10.6 Item 1)
16	-	Spring (P/O PL 10.6 Item 1)
17	-	Spring (P/O PL 10.6 Item 1)
