WorkCentre 5335 Family Service Documentation

705P01303

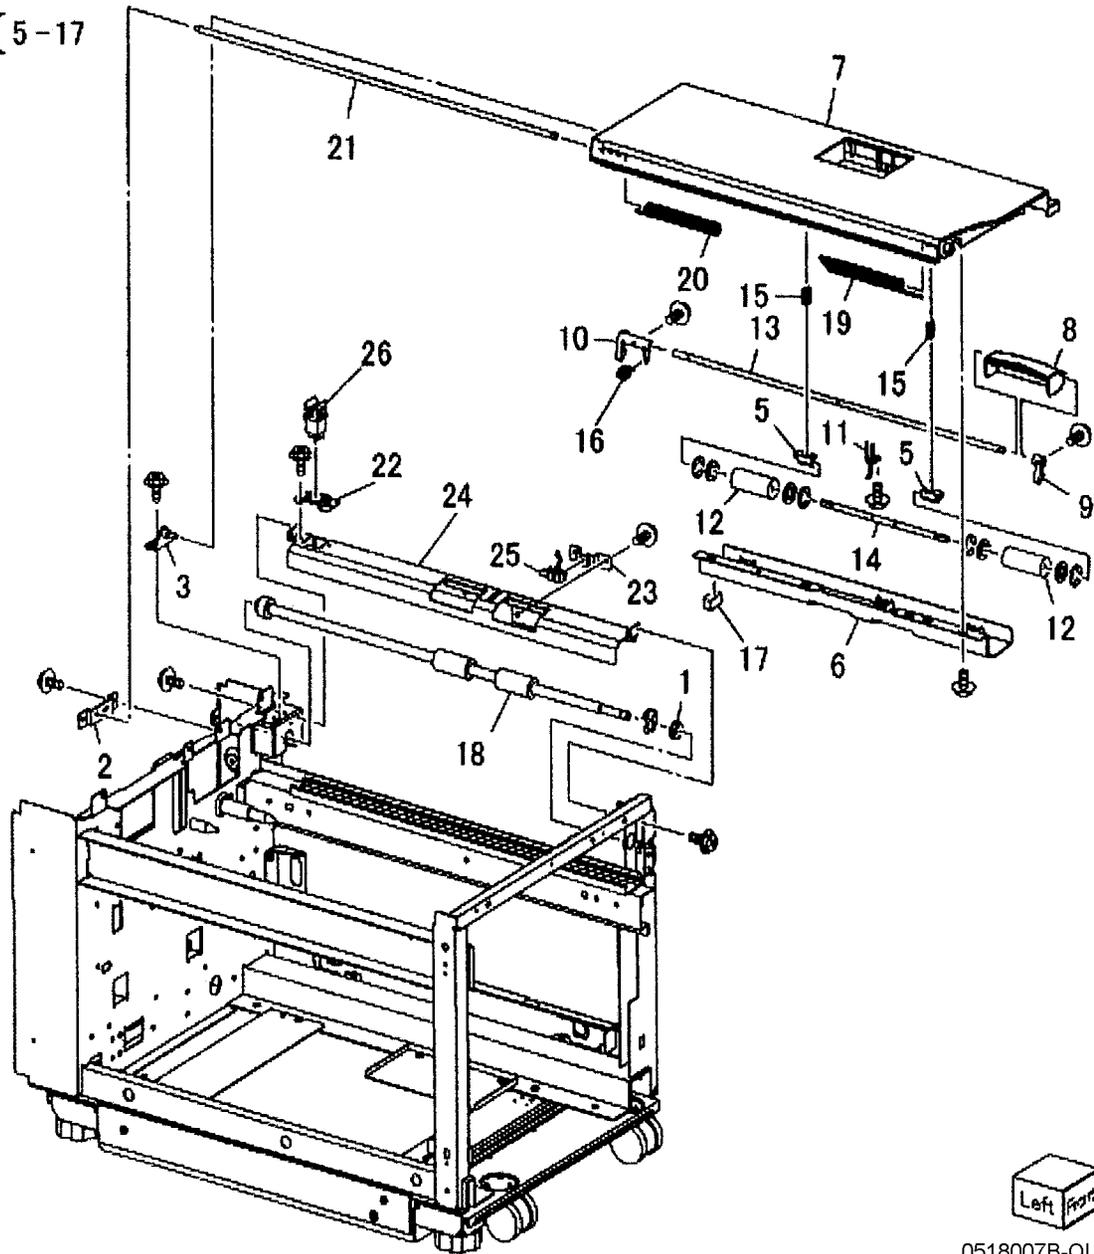
PL 10.7 HCF Top Cover Unit

Item	Part	Description
1	013E17100	Bearing
2	-	Bracket (Not Spared)
3	-	Pivot Bracket (Not Spared)
4	-	Top Cover Assembly (Not Spared)
5	-	Bearing (P/O PL 10.7 Item 4)
6	-	Upper Chute (P/O PL 10.7 Item 4)
7	-	Top Cover (P/O PL 10.7 Item 4)
8	-	Knob (P/O PL 10.7 Item 4)
9	-	Latch (P/O PL 10.7 Item 4)
10	-	Latch (P/O PL 10.7 Item 4)
11	-	Spring (P/O PL 10.7 Item 4)
12	059E01430	Pinch Roller
13	-	Shaft (P/O PL 10.7 Item 4)
14	-	Shaft (P/O PL 10.7 Item 4)
15	-	Spring (P/O PL 10.7 Item 4)
16	-	Spring (P/O PL 10.7 Item 4)
17	-	Gasket (P/O PL 10.7 Item 4)
18	059K36260	Takeaway Roll (REP 19.10)
19	-	Spring (Left) (P/O PL 10.1 Item 16)
20	-	Spring (Right) (P/O PL 10.1 Item 16)
21	-	Pivot Shaft (P/O PL 10.1 Item 16)
22	-	Bracket (P/O PL 10.1 Item 16)
23	-	Bracket (P/O PL 10.1 Item 16)
24	-	Lower Chute (P/O PL 10.1 Item 16)
25	130K88150	Takeaway Sensor
26	110E94770	Top Cover Interlock Switch

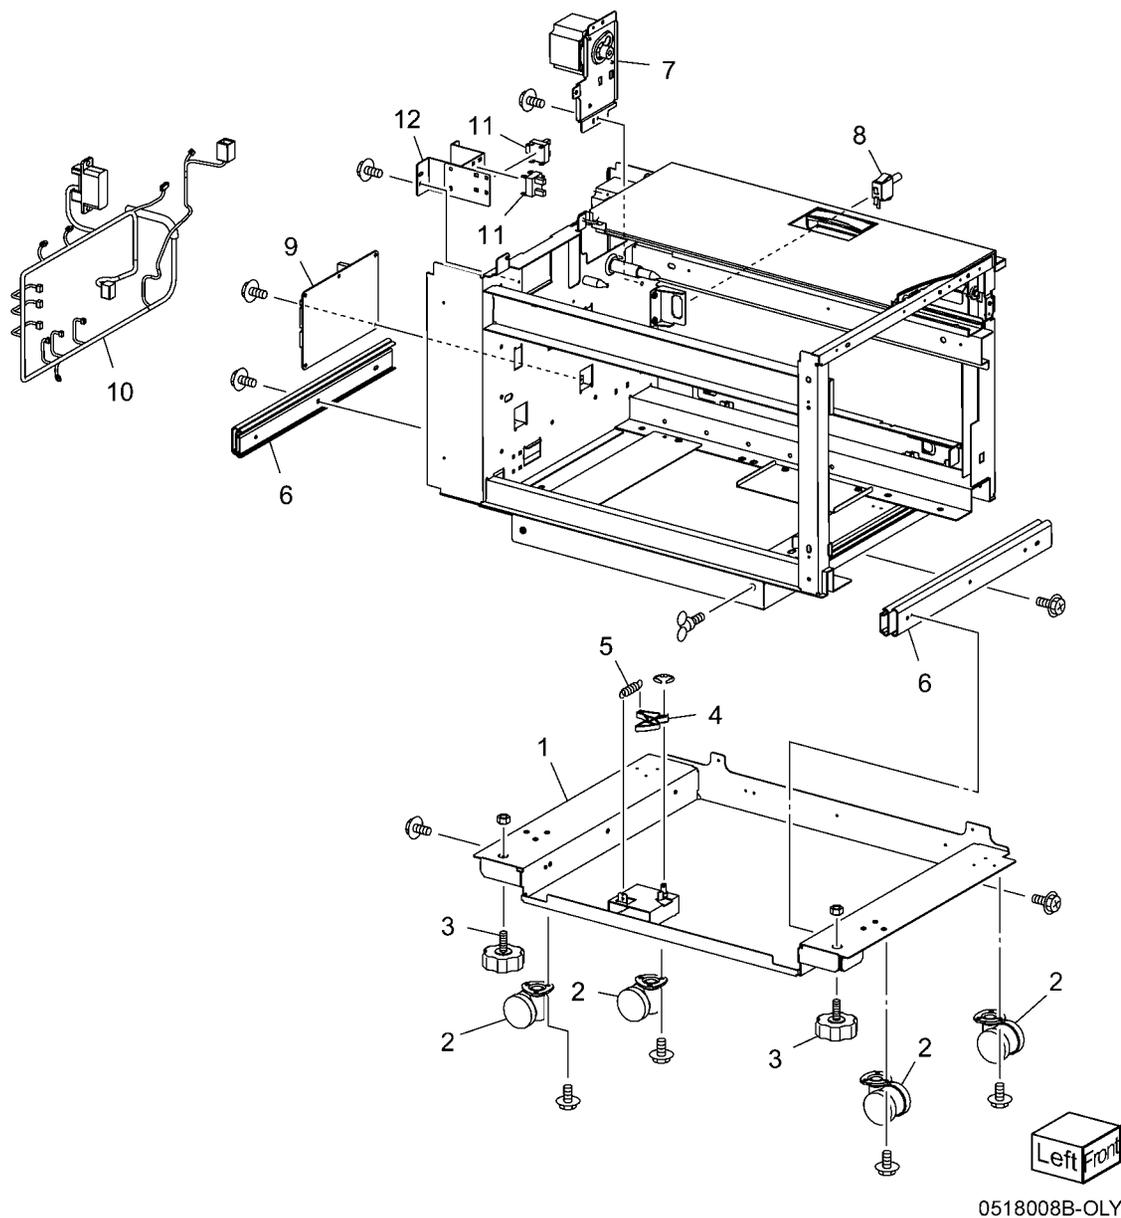
PL 10.8 HCF Electrical and Rail

Item	Part	Description
1	—	Plate (Not Spared)
2	017E92820	Rack Caster (REP 19.9)
3	—	Foot (Not Spared)
4	—	Latch Lever (Not Spared)
5	—	Spring (Not Spared)
6	801K15690	Rail
7	127K47150	Takeaway Motor
8	—	Docking Interlock Switch (Not Spared)
9	960K31492	HCF PWB (REP 19.11)
10	—	Wire Harness (P/O PL 10.1 Item 16)
11	130K55590	HCF Size Sensor R and L
12	—	Bracket (P/O PL 10.1 Item 16)

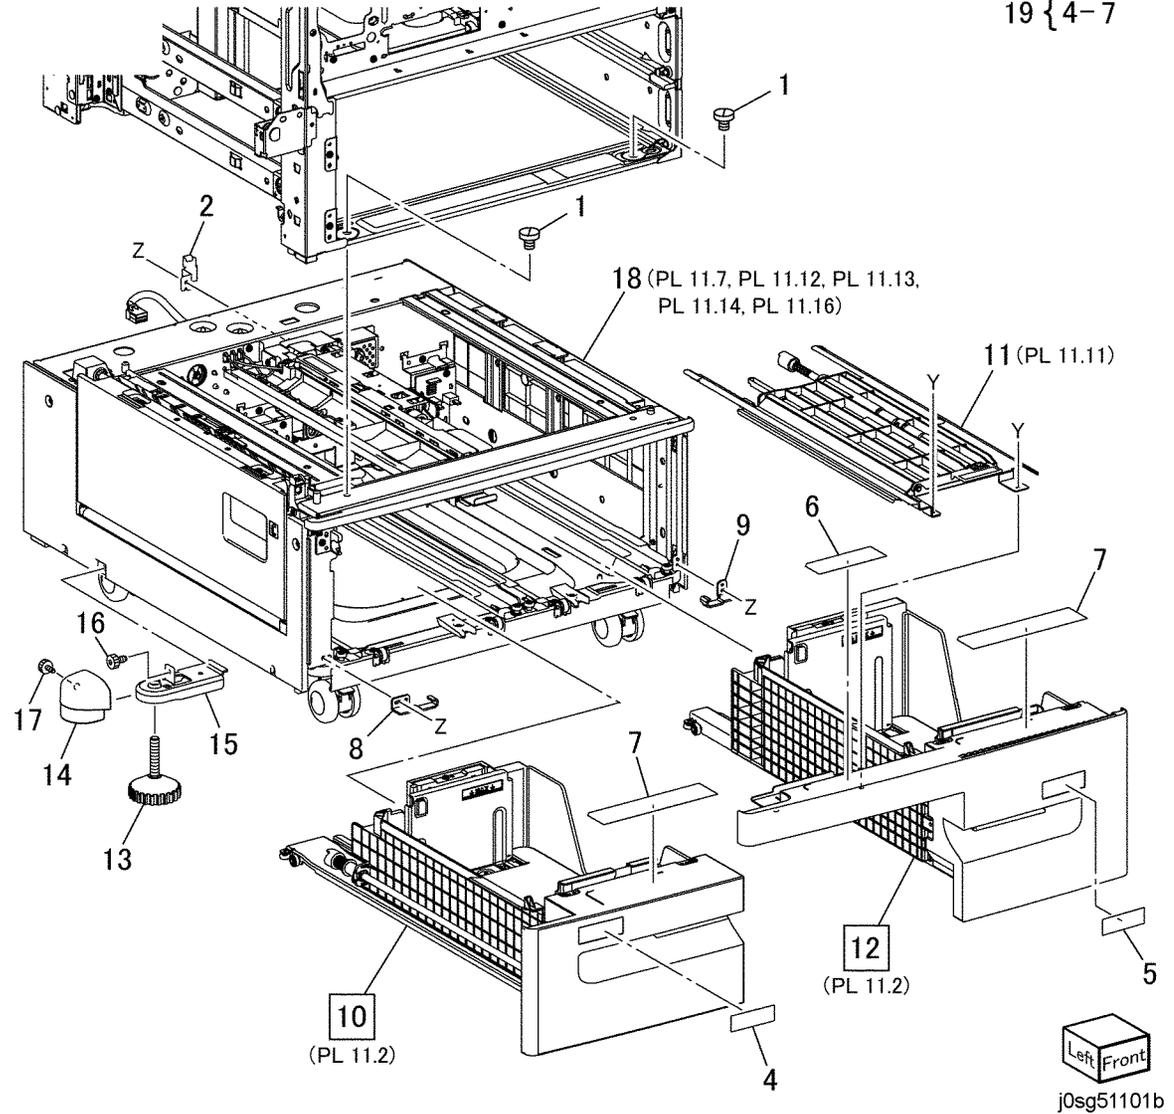
PL 11.1 Tray Module (TTM) (Option)

Item	Part	Description
1	826E48400	Docking Screw
2	849E13150	Docking Bracket
3	-	Tray Module (TTM) (Not Spared) (Includes Items 4-17)
4	-	Label (Tray No.3) (P/O PL 11.1 Item 19)
5	-	Label (Tray No.4) (P/O PL 11.1 Item 19)
6	-	Label (TTM) (P/O PL 11.1 Item 19)
7	-	Label (Instruction TTM) (P/O PL 11.1 Item 19)
8	803E09040	Stopper (Tray 3)
9	803E09030	Stopper (Tray 4)
10	050K66262	Tray 3 Assembly (REF: PL 11.2)
11	059K71810	Transport Assembly (REF: PL 11.11)
12	050K66242	Tray 4 Assembly (REF: PL 11.2)
13	017K94590	Adjuster Foot Assembly
14	848E52692	Foot Cover
15	868E51271	Foot Bracket
16	-	Screw Tap (Not Spared)
17	826E28400	Screw Tap
18	032E37871	Guide Transport
19	604K68210	Label Kit (Includes Items 4-7)

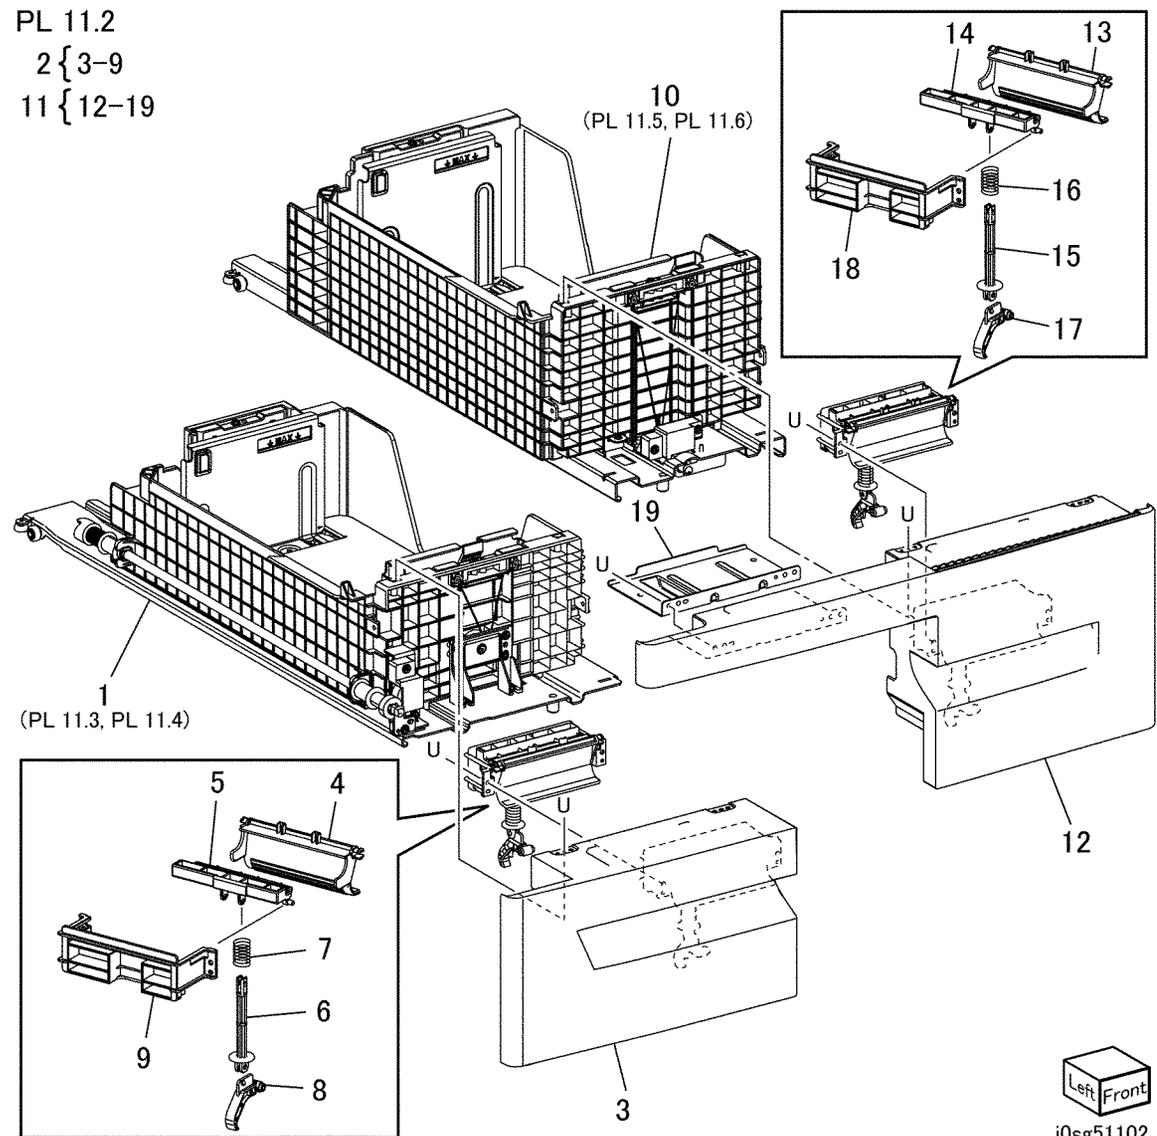
PL 11.2 Tray 3/4 Assembly

Item	Part	Description
1	-	Tray 3 Assembly (REF: PL 11.3, PL 11.4) (REP 7.1)
2	848K49481	Tray 3 Front Cover Assembly (Includes Items 3-9)
3	-	Tray 3 Front Cover (Not Spared)
4	-	Lever (Not Spared)
5	-	Link (Not Spared)
6	-	Link (Not Spared)
7	-	Spring (Not Spared)
8	-	Latch (Not Spared)
9	-	Cover (P/O PL 11.2 Item 2)
10	-	Tray 4 Assembly (REF: PL 11.5, PL 11.6) (REP 7.1)
11	848K49471	Tray 4 Front Cover Assembly (Includes Items 12-19)
12	-	Tray 4 Front Cover (Not Spared)
13	-	Lever (Not Spared)
14	-	Link (Not Spared)
15	-	Link (Not Spared)
16	-	Spring (Not Spared)
17	-	Latch (Not Spared)
18	-	Cover (P/O PL 11.2 Item 11)
19	-	Transport Bracket (P/O PL 11.2 Item 11)

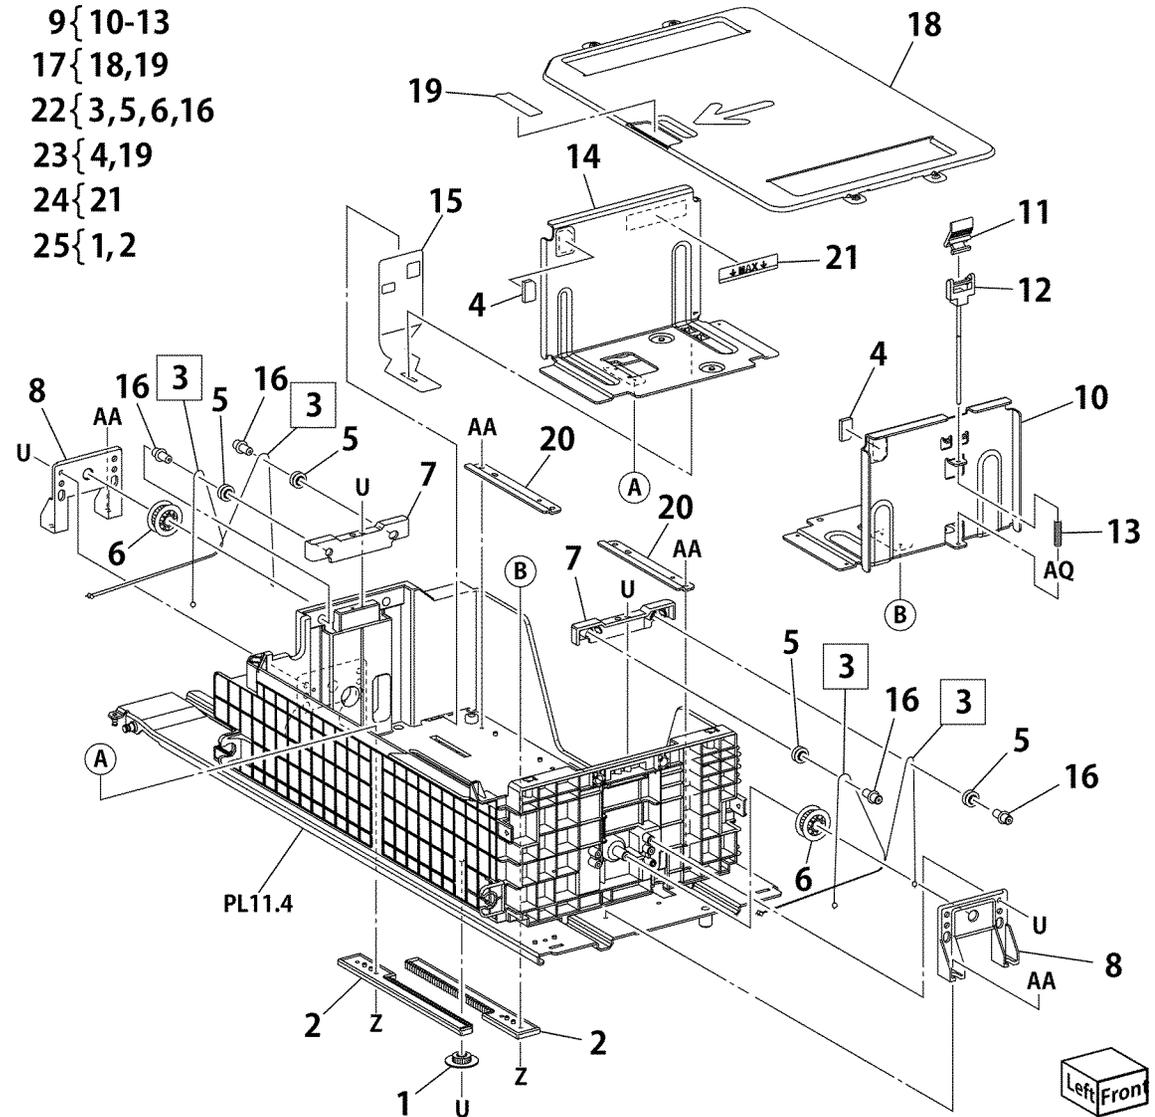
PL 11.3 Tray 3 Assembly (1 of 2)

Item	Part	Description
1	-	Pinion (P/O PL 11.3 Item 25)
2	-	Rack Gear (P/O PL 11.3 Item 25)
3	-	Cable LT (P/O PL 11.3 Item 22) (REP 7.3)
4	019E71680	Pad
5	-	Pulley (S) (P/O PL 11.3 Item 22)
6	-	Pulley (L) (P/O PL 11.3 Item 22)
7	-	Guide (Not Spared)
8	-	Guide (Not Spared)
9	038K20970	Side Guide Assembly (Includes Items 10-13)
10	-	Side Guide (P/O PL 11.3 Item 9)
11	-	Knob (P/O PL 11.3 Item 9)
12	-	Knob Assembly (P/O PL 11.3 Item 9)
13	-	Spring (P/O PL 11.3 Item 9)
14	-	Guide Assembly (Not Spared)
15	-	Size Actuator (Not Spared)
16	-	Shaft (P/O PL 11.3 Item 22)
17	-	Bottom Plate Assembly (Not Spared) (Includes Items 18, 19)
18	-	Plate (P/O PL 11.3 Item 17)
19	019K09580	Pad
20	-	Side Bracket (Not Spared)
21	-	Label (Max) (P/O PL 11.3 Item 24)
22	604K68170	Pulley Cable Kit (Includes Items 3, 5, 6, 16)
23	604K68180	Pad Kit
24	604K68210	Label Kit (Includes Items 21)
25	604K68260	Rack and Pinion Kit (Includes Items 1, 2)

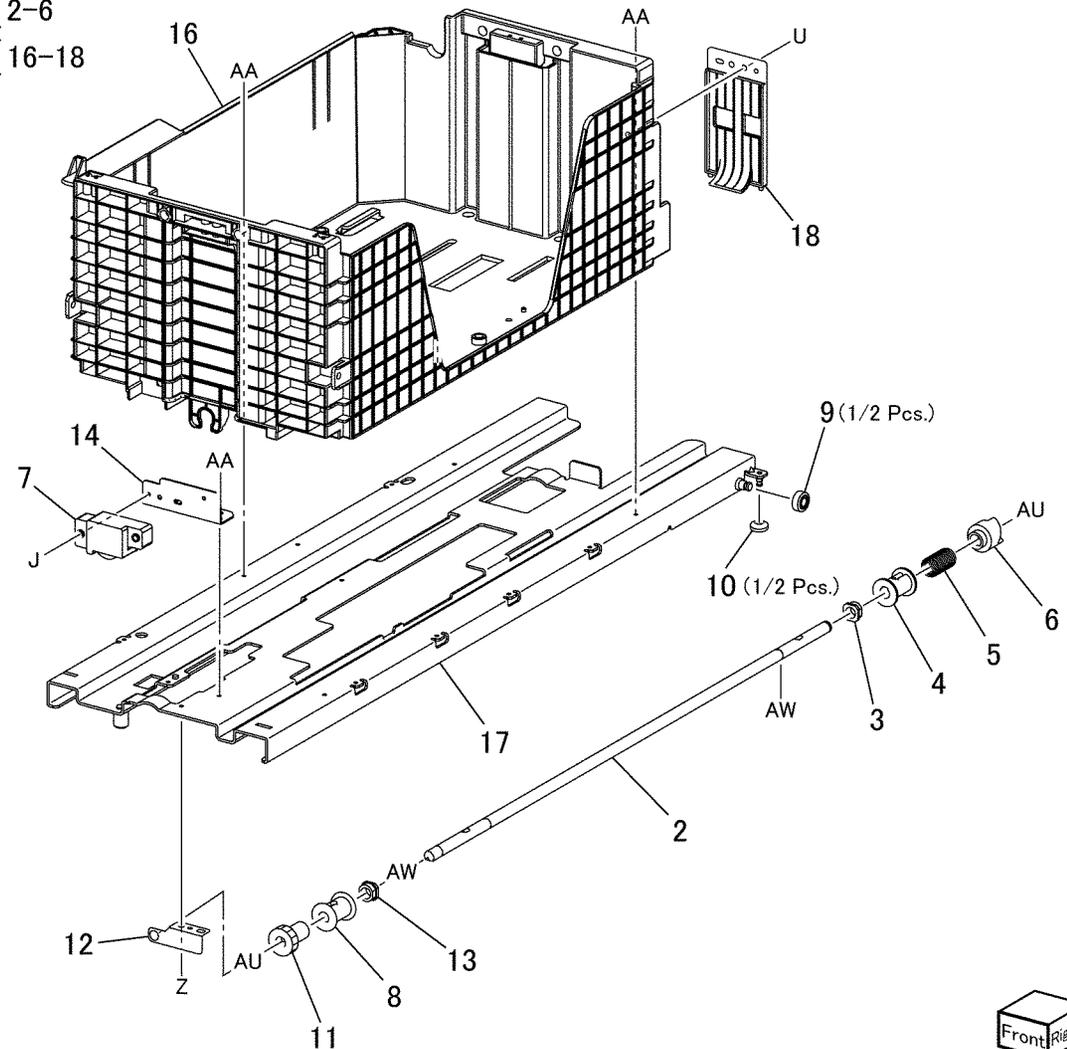
PL 11.6 Tray 4 Assembly (2 of 2)

Item	Part	Description
1	006K89421	Lift Shaft Assembly (Includes Items 2-6)
2	-	Lift Shaft (P/O PL 11.6 Item 1)
3	413W11860	Bearing
4	-	Pulley (P/O PL 11.6 Item 1)
5	-	Spring (P/O PL 11.6 Item 1)
6	-	Joint (P/O PL 11.6 Item 1)
7	019K93921	Brake Assembly
8	-	Pulley (Not Spared)
9	-	Upper Roll (Not Spared)
10	059E05060	Upper Roll
11	-	Gear (18T) (Not Spared)
12	-	Spring (Not Spared)
13	-	Sleeve Bearing (Not Spared)
14	-	Bracket (Not Spared)
15	-	Cassette Assembly (Not Spared) (Includes Items 16-18)
16	-	Cassette (P/O PL 11.6 Item 15)
17	-	Rail (P/O PL 11.6 Item 15)
18	-	Cover (P/O PL 11.6 Item 15)

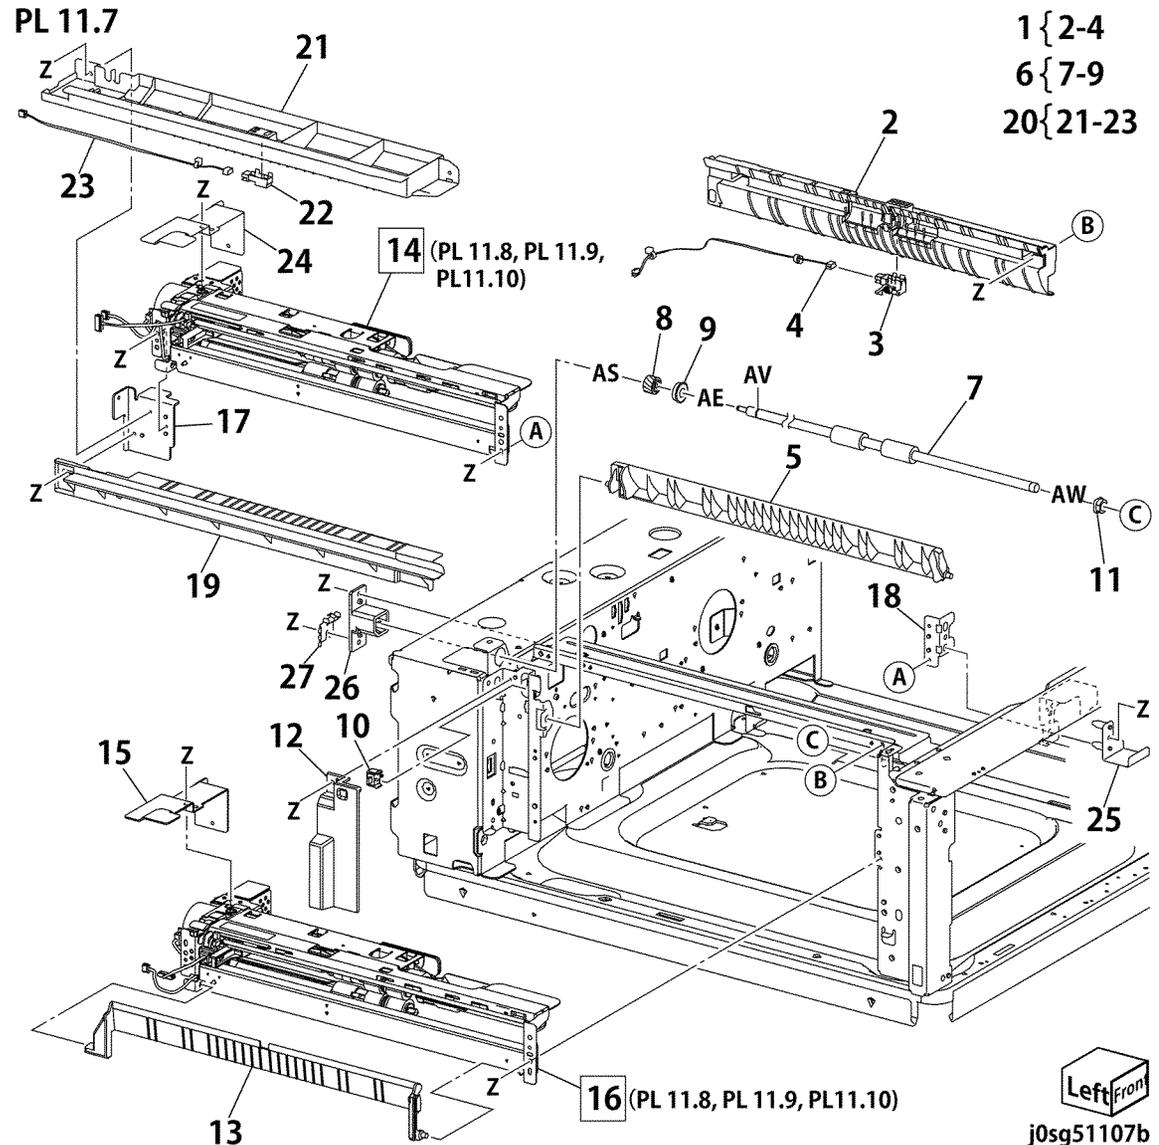
PL 11.7 Tray 3/4 Feeder Assembly, T/A Roll Assembly

Item	Part	Description
1	054K46240	Chute Assembly (Includes Items 2-4)
2	—	Chute (Not Spared)
3	130K76530	Feed Out Sensor 3
4	—	Harness Assembly (Feed/Out 3) (Not Spared)
5	054E46500	Chute Feed Transport
6	059K71510	T/A Roll Assembly (Includes Item 7-9)
7	—	T/A Roll (Not Spared)
8	—	Gear (16T) (Not Spared)
9	—	Bearing (Not Spared)
10	110E12220	TM L/H Cover Interlock Switch
11	—	Bearing (Not Spared)
12	—	Harness Cover (Not Spared)
13	054E33802	Feed Out Chute
14	059K74280	Tray 3 Feeder Assembly (PL 11.8) (REP 8.3)
15	—	Cover (Not Spared)
16	—	Tray 4 Feeder Assembly (PN Same as Item 14) (REP 8.4)
17	—	Bracket (Not Spared)
18	—	Bracket (Not Spared)
19	—	Low Chute (Not Spared)
20	054K46340	Chute Assembly (Includes Items 21-23)
21	—	Chute (P/O PL 11.7 Item 20)
22	930W00212	Feed Out Sensor 4
23	—	Harness Assembly (Feed/Out 4) (P/O PL 11.7 Item 20)
24	—	Cover (Not Spared)
25	—	Pivot Bracket (Not Spared)
26	032E37871	Transport Guide

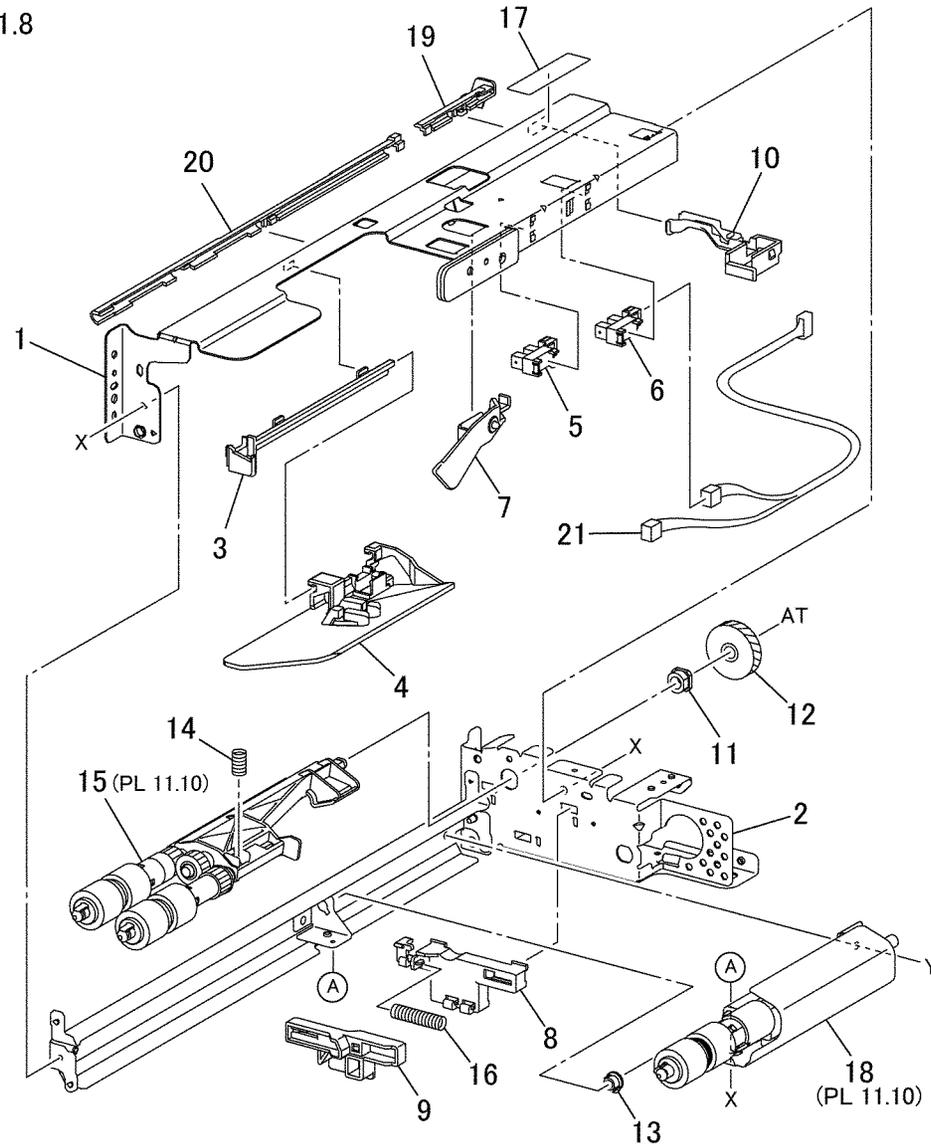
PL 11.8 Tray 3/4 Feeder Assembly (1/2)

Item	Part	Description
1	-	Upper Frame (Not Spared)
2	-	Lower Frame (Not Spared)
3	-	Rail (Not Spared)
4	-	Chute (Not Spared)
5	930W00123	Tray 3/4 Level Sensor
6	930W00113	Tray 3/4 No Paper Sensor
7	120E22481	Actuator
8	-	Holder (Not Spared)
9	-	Lever (Not Spared)
10	-	Harness Holder (Not Spared)
11	413W11660	Bearing
12	-	Gear 30T (Not Spared)
13	-	Bearing (Not Spared)
14	-	Spring (Not Spared)
15	-	Feed/Nudger Roll Assembly (REF: PL 11.10)
16	-	Spring (Not Spared)
17	-	Traceability Label (Not Spared)
18	-	Retard Roll Assembly (REF: PL 11.10)
19	-	Rear Harness Holder (Not Spared)
20	-	Center Harness Holder (Not Spared)
21	-	Wire Harness (Not Spared)

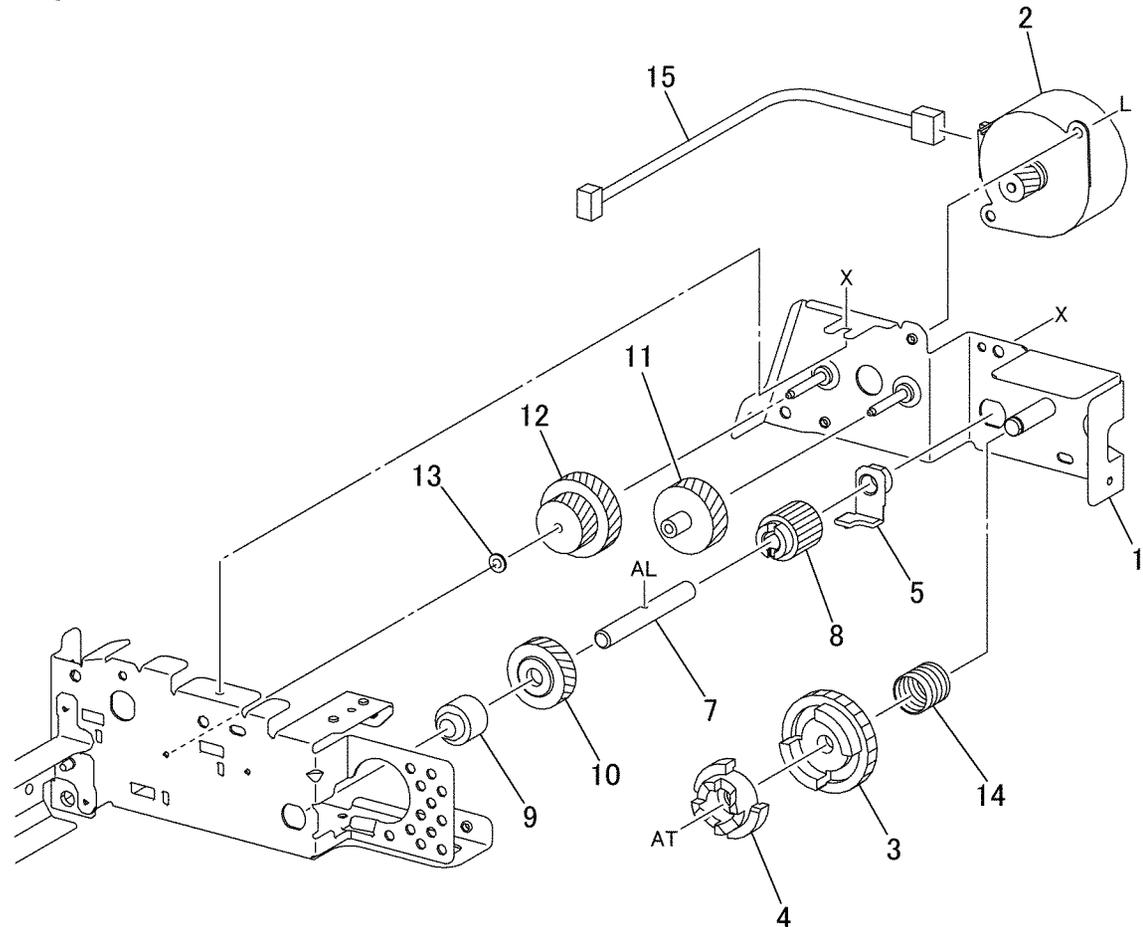
PL 11.9 Tray 3/4 Feeder Assembly (2/2)

Item	Part	Description
1	-	Drive Bracket Assembly (Not Spared)
2	127K52790	Tray 3/4 Lift/Feed Motor
3	-	Gear (31T) (Not Spared)
4	-	Spacer (Not Spared)
5	-	Shaft Bearing (Not Spared)
6	-	Drive Shaft Assembly (Not Spared) (Includes Item 7)
7	-	Drive Shaft (Not Spared)
8	-	Gear (13T) (Not Spared)
9	005K07130	Oneway Clutch
10	007K97870	Oneway Gear
11	-	Gear (25T) (Not Spared)
12	-	Gear (29T/19T) (Not Spared)
13	-	Washer (Not Spared)
14	-	Spring (Not Spared)
15	-	Wire Harness (Not Spared)

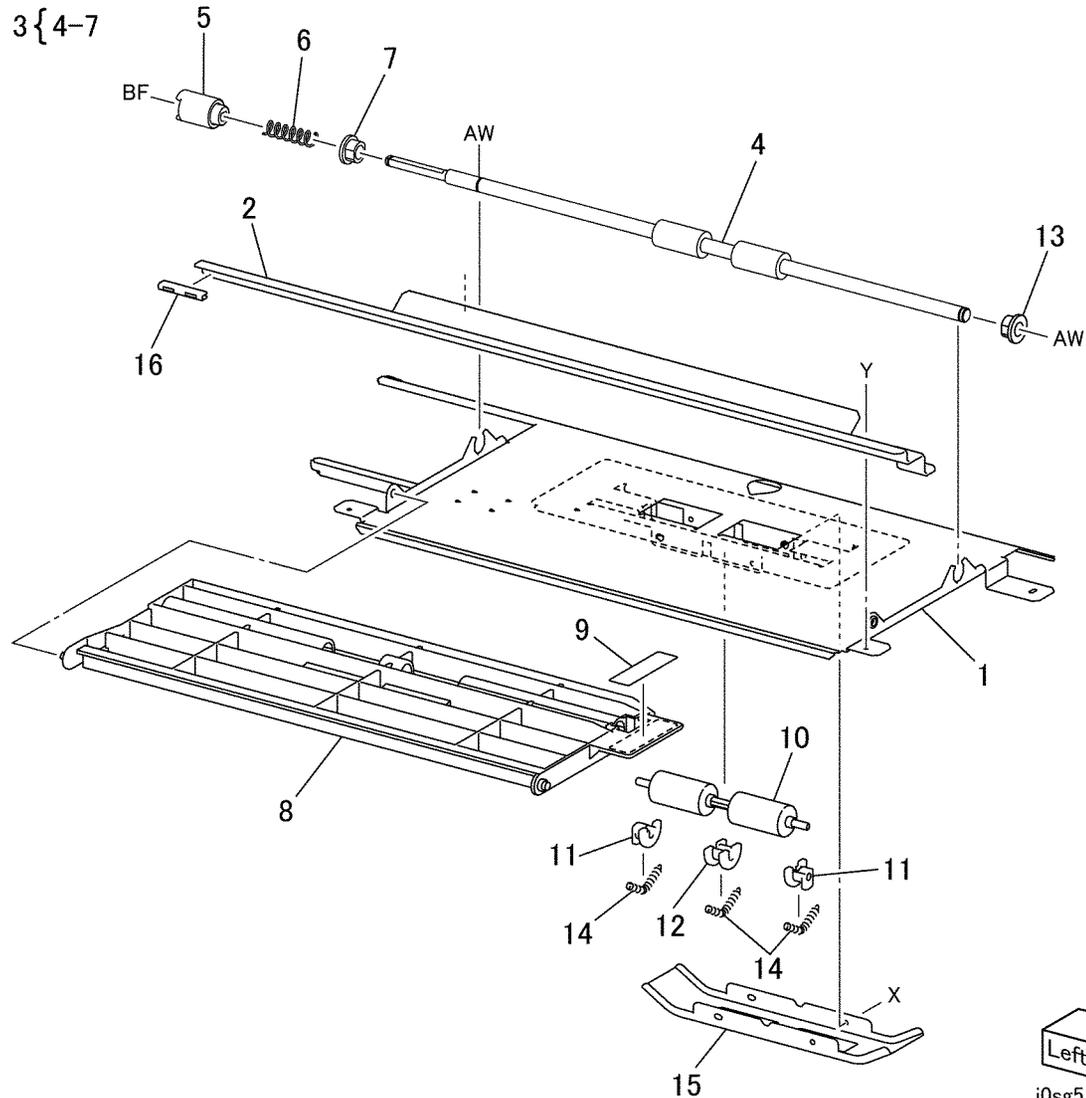
PL 11.11 Tray 3/4 Transport Assembly

Item	Part	Description
1	-	Chute Ay Low (Not Spared)
2	-	Rail Transport Lh (Not Spared)
3	059K26350	T/A Roll Assembly (Includes Items 4-7)
4	-	T/A Roll (P/O PL 11.11 Item 3)
5	-	Joint (P/O PL 11.11 Item 3)
6	-	Spring (P/O PL 11.11 Item 3)
7	-	Bearing (P/O PL 11.11 Item 3)
8	-	Chute Uo Trs (Not Spared)
9	-	Label Transport (Not Spared)
10	059E98860	Roll Pinch Transport
11	-	Bearing 2 (Not Spared)
12	-	Bearing 1 (Not Spared)
13	413W77559	Bearing
14	-	Spring (Not Spared)
15	-	Cover Pinch (Not Spared)
16	-	Spacer Rail (Not Spared)

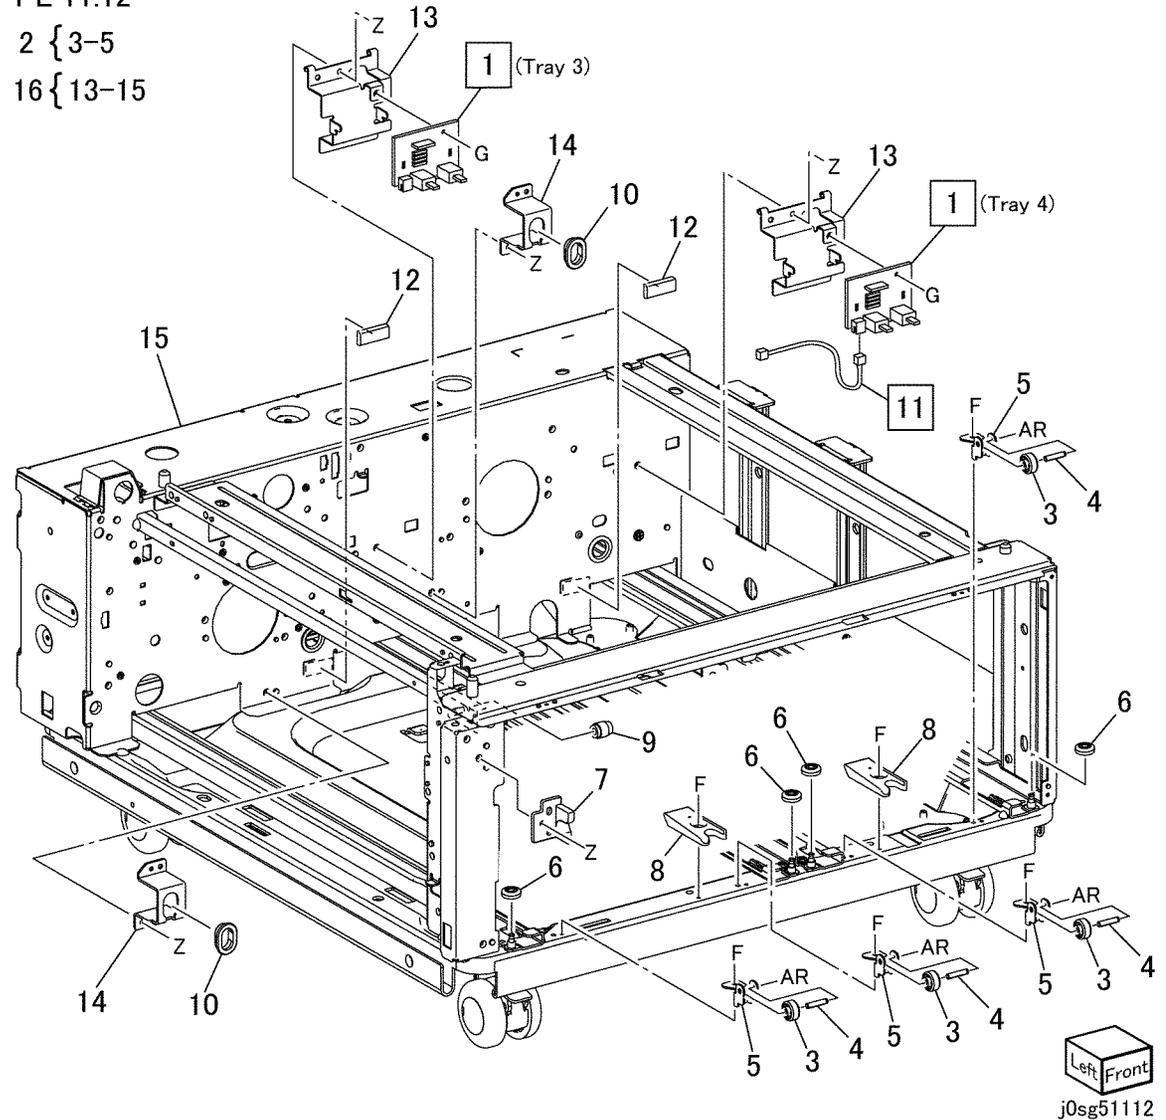
PL 11.12 Tray 3/4 Switch Assembly

Item	Part	Description
1	110K15040	Tray 3 Size Switch
2	049K08250	Bracket Assembly (Includes Items 3-5)
3	-	Roll (P/O PL 11.12 Item 2)
4	-	Shaft (P/O PL 11.12 Item 2)
5	-	Bracket (P/O PL 11.12 Item 2)
6	059E05060	Roller Upper
7	-	Stopper Location Fr (Not Spared)
8	803E09020	Stopper
9	059E05131	Roller TR
10	-	Bracket Cv (Not Spared)
11	-	Harness Assembly Switch 4 (Not Spared)
12	-	Gasket (Not Spared)
13	-	Switch Bracket (Not Spared)
14	-	Bracket (Not Spared)
15	-	TTM Frame (P/O PL 11.12 Item 16)
16	-	TTM Frame Assembly (Not Spared) (Includes Items 13-15)

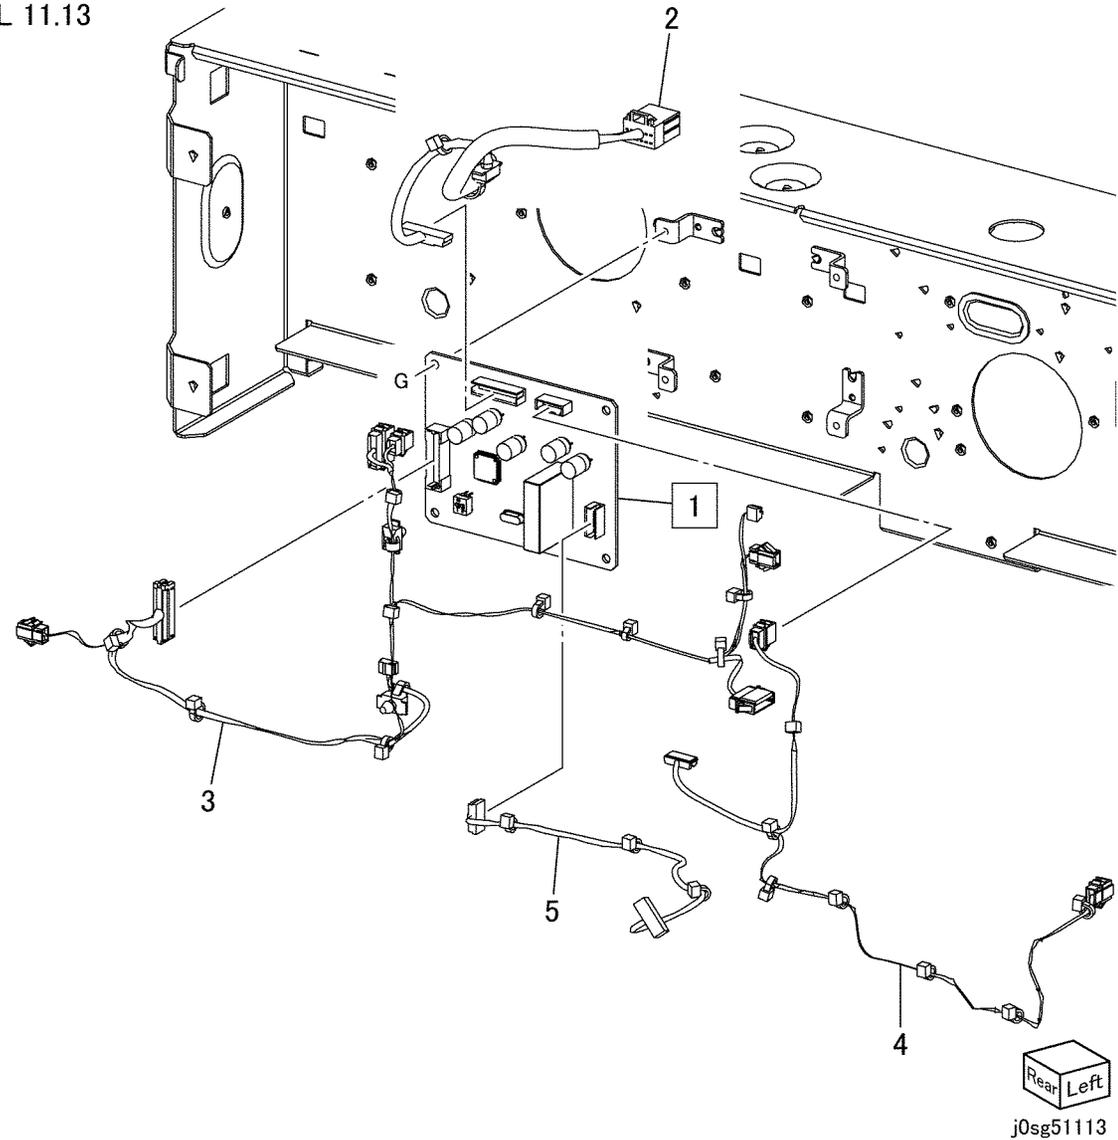
PL 11.13 Wire Harness

Item	Part	Description
1	960K55022	Tray Module PWB
2	-	Wire Harness (IF) (Not Spared)
3	-	Wire Harness (Sensor) (Not Spared)
4	-	Wire Harness (Motor 1) (Not Spared)
5	-	Wire Harness (Motor 2) (Not Spared)

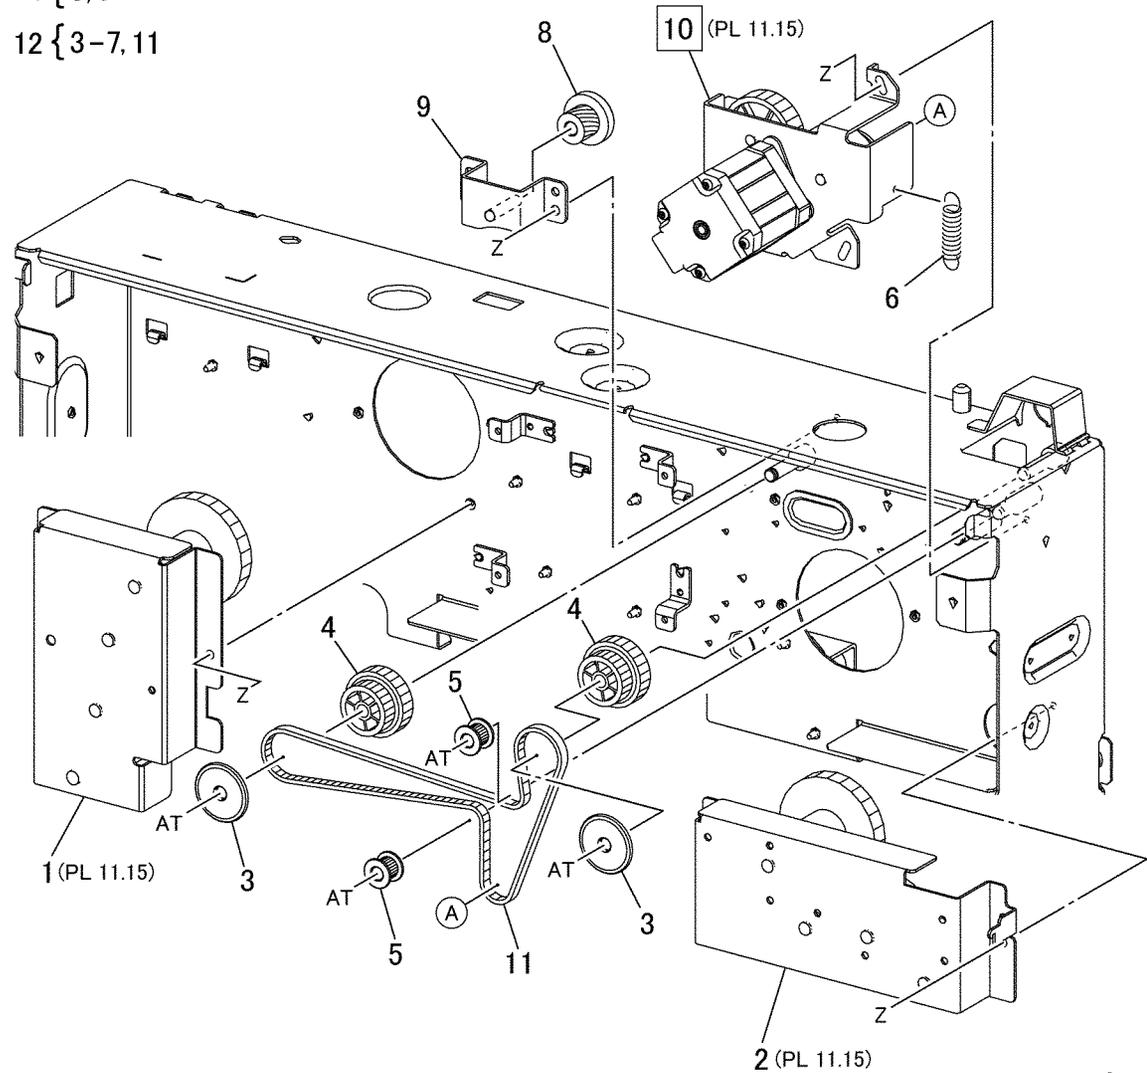
PL 11.14 TM Drive

Item	Part	Description
1	049K07530	Gear Assembly (REF: PL 11.15)
2	049K07520	Bracket Assembly (REF: PL 11.15)
3	-	Collar 2 (P/O PL 11.14 Item 12)
4	-	Pulley (P/O PL 11.14 Item 12)
5	-	Roll (P/O PL 11.14 Item 12)
6	-	Spring (P/O PL 11.14 Item 12)
7	-	Gear Assembly (P/O PL 11.14 Item 12) (Includes Items 8, 9)
8	-	Gear (P/O PL 11.14 Item 7)
9	-	Bracket (P/O PL 11.14 Item 7)
10	049K07400	TM Takeaway Motor Assembly (REF: PL 11.15)
11	-	Belt (P/O PL 11.14 Item 12)
12	604K68200	Take Away Gear Kit (Includes Item 3-7, 11)

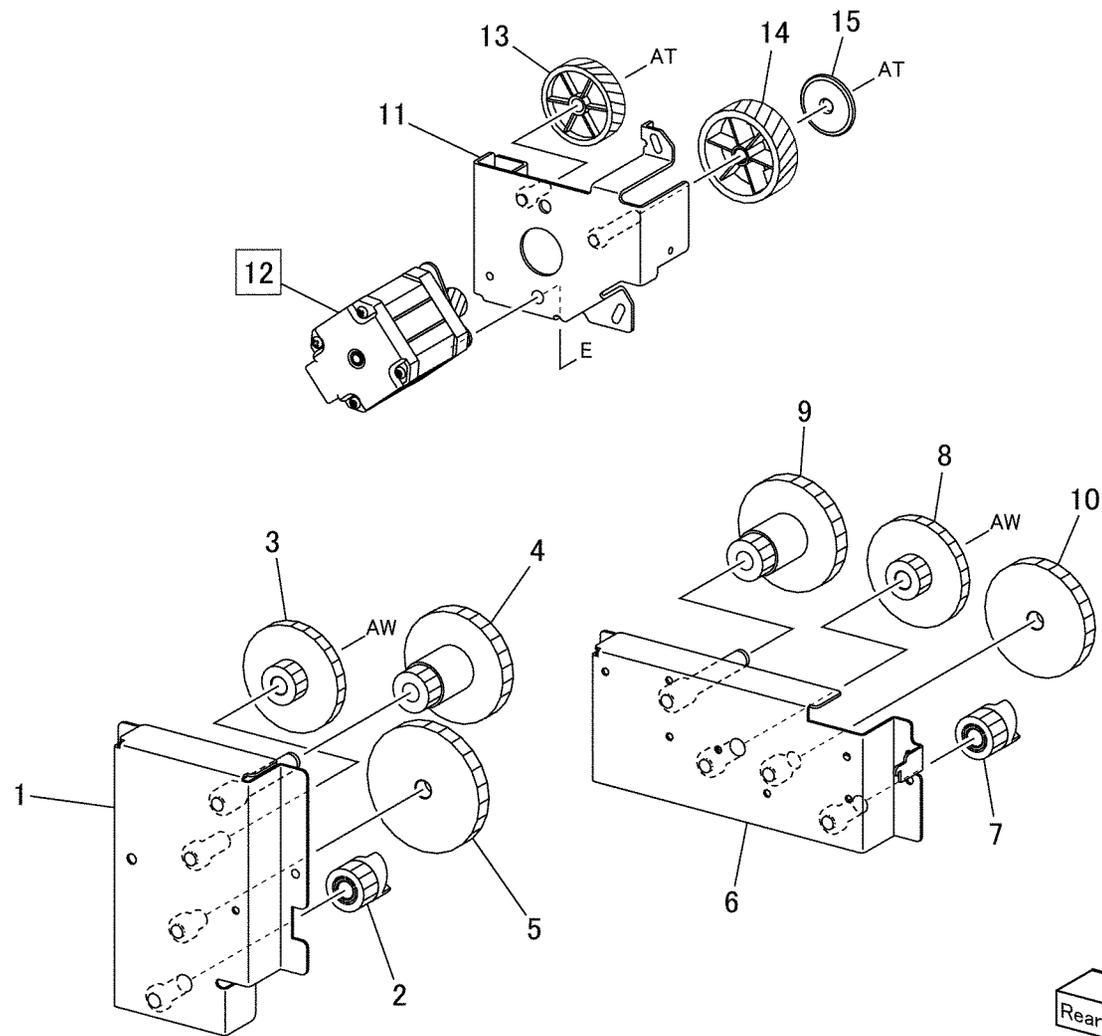
PL 11.15 Takeaway Motor Assembly

Item	Part	Description
1	-	Bracket Assembly (Not Spared)
2	-	Gear (18T) (Not Spared)
3	-	Lift Gear (Not Spared)
4	-	Lift Gear (Not Spared)
5	-	Lift Gear (57) (Not Spared)
6	-	Bracket Assembly, TM Take Away Motor (Not Spared)
7	-	Gear (18T) (Not Spared)
8	-	Lift Gear (Not Spared)
9	-	Lift Gear (Not Spared)
10	-	Lift Gear (51) (Not Spared)
11	-	Bracket Assembly (Not Spared)
12	-	TM Take Away Motor (Not Spared)
13	-	Gear (70T) (Not Spared)
14	-	Gear (81T) (Not Spared)
15	-	Collar (Not Spared)

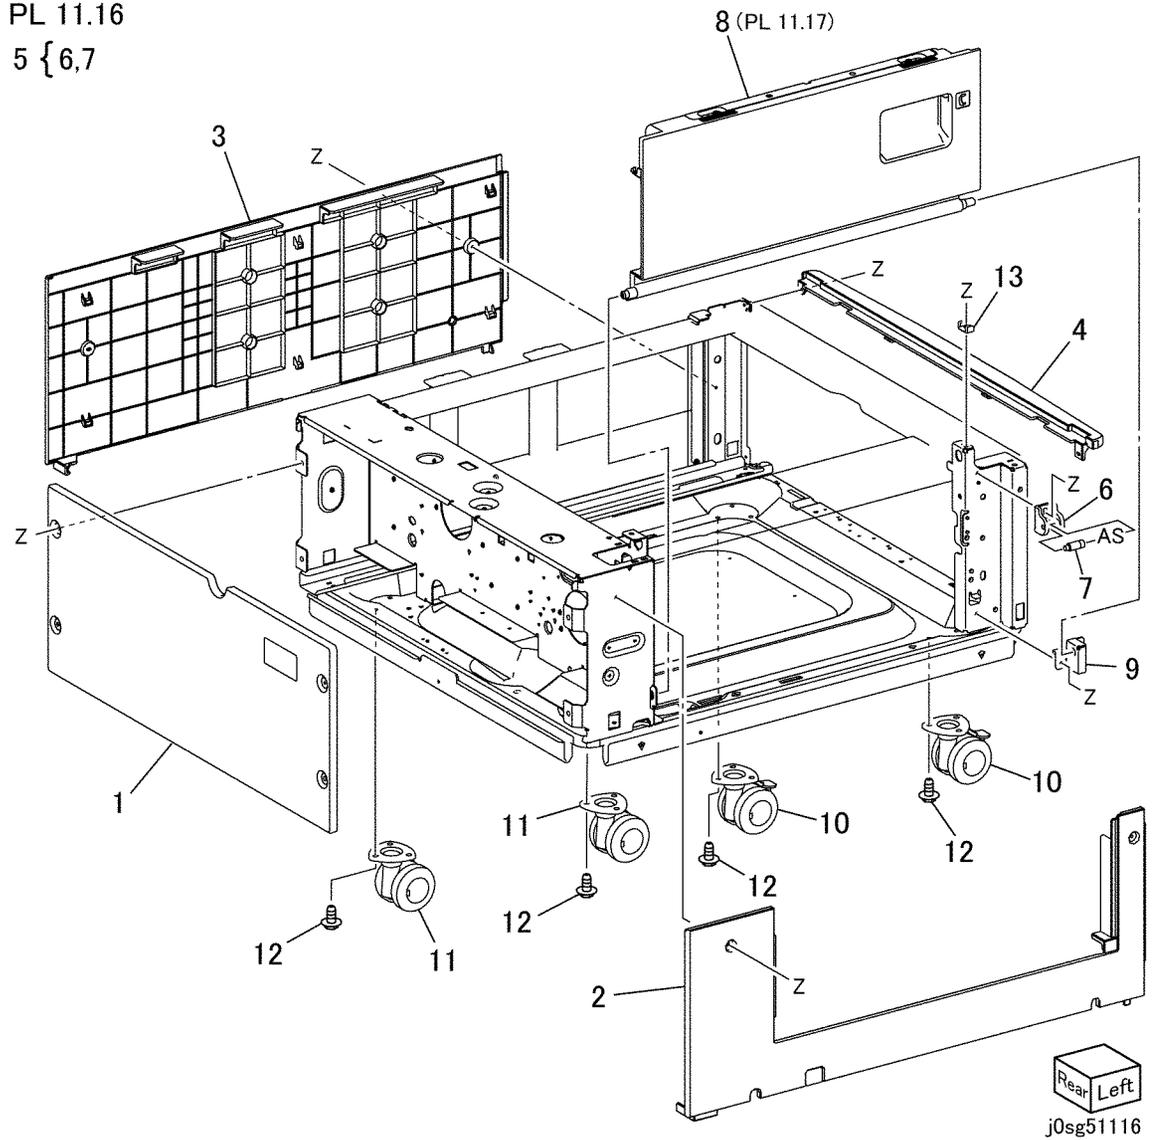
PL 11.16 Cover

Item	Part	Description
1	-	Rear Cover (Not Spared)
2	-	Left Cover (Not Spared)
3	-	Right Cover (Not Spared)
4	-	Top Cover (Not Spared)
5	-	Latch Assembly (Not Spared) (Includes Items 6, 7)
6	-	Latch (P/O PL 11.16 Item 5)
7	-	Shaft (P/O PL 11.16 Item 5)
8	848K49451	L/H Cover Assembly (REF: PL 11.17)
9	-	Pivot Bracket (Not Spared)
10	417W41349	Locking Caster
11	417W41449	Caster
12	-	Screw (Not Spared)
13	-	Support Block (Not Spared)

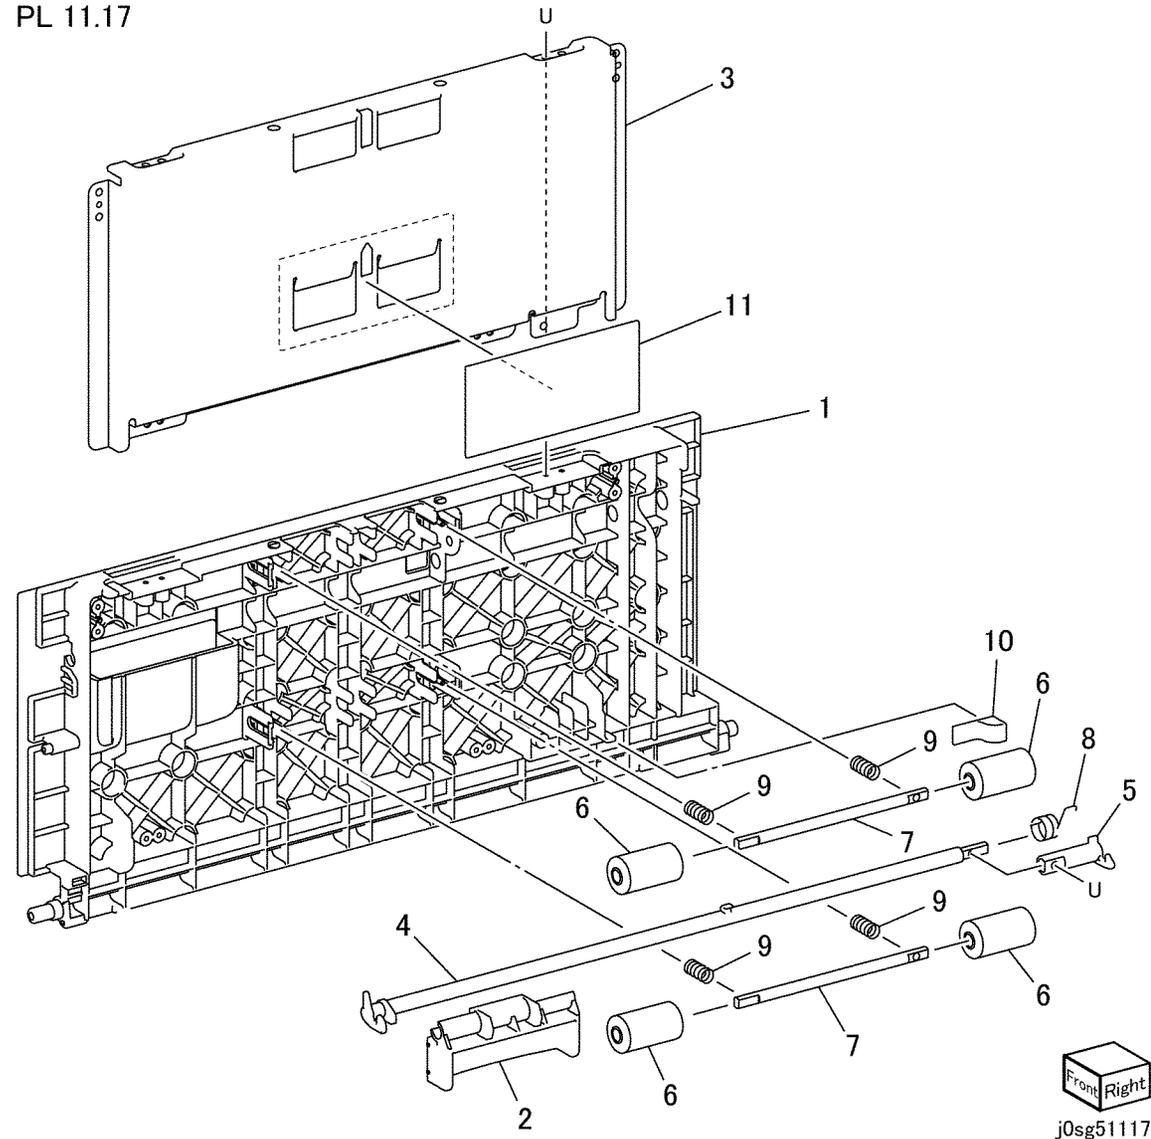
PL 11.17 L/H Cover Assembly

Item	Part	Description
1	-	L/H Cover (Not Spared)
2	-	Handle (Not Spared)
3	-	L/H Chute (Not Spared)
4	-	Latch (Not Spared)
5	-	Hook (Not Spared)
6	059E99241	Pinch Roll
7	-	Pinch Shaft (Not Spared)
8	-	Latch Spring (Not Spared)
9	-	Pinch Spring (Not Spared)
10	-	Gasket (Not Spared)
11	-	Label (Not Spared)
