WorkCentre 5335 Family Service Documentation

705P01303

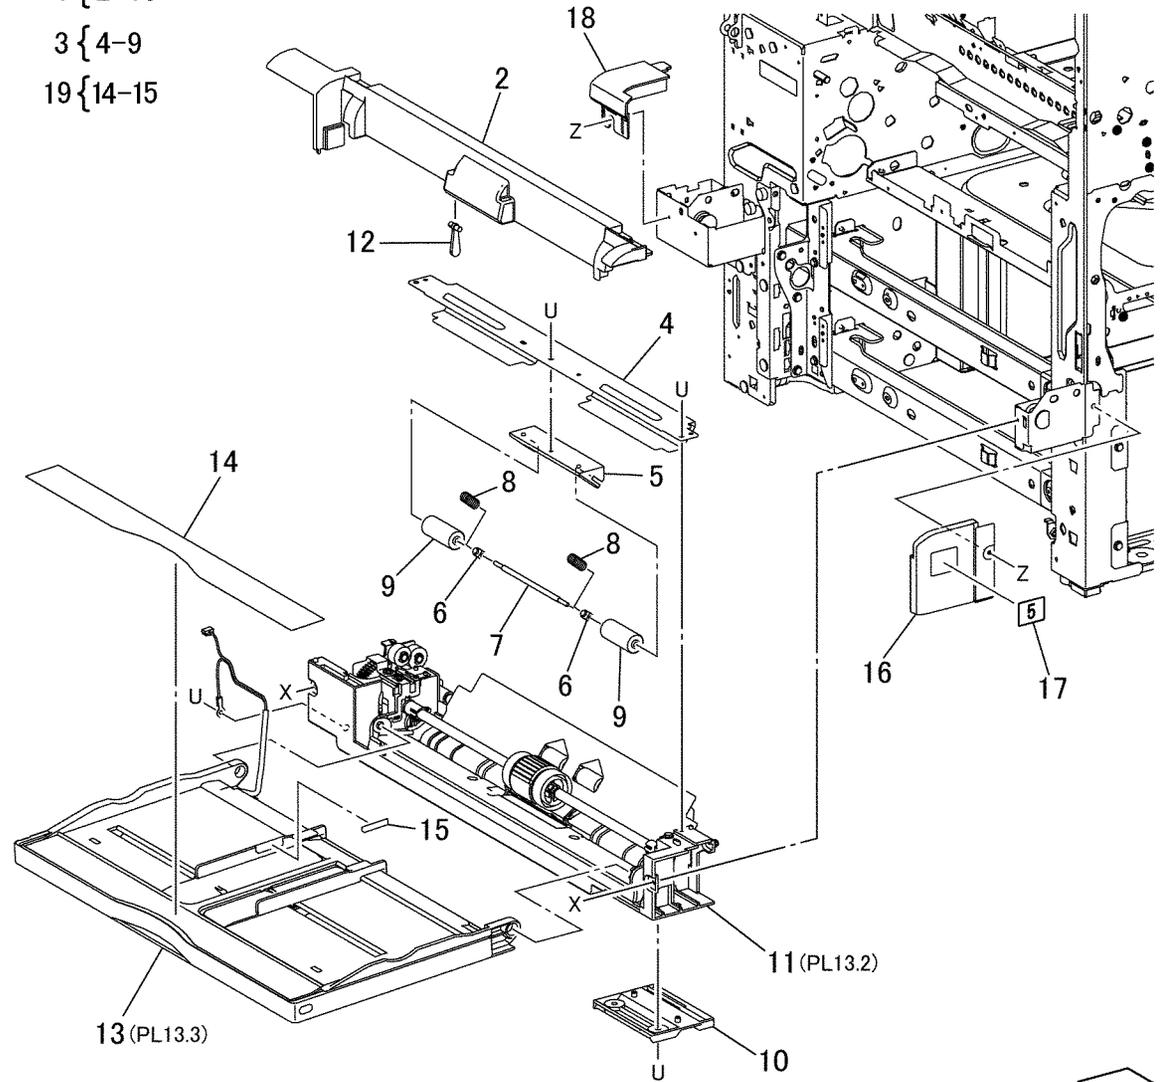
PL 13.1 MSI Assembly

Item	Part	Description
1	059K71260	MSI Assembly (Includes Items 2-15) (REP 7.2)
2	-	MSI Top Cover (P/O PL 13.1 Item 1)
3	054K45960	Pinch Chute Assembly (Includes Items 4-9)
4	-	Pinch Chute (P/O PL 13.1 Item 3)
5	-	Pinch Guide (P/O PL 13.1 Item 3)
6	-	Pinch Spring Spacer (P/O PL 13.1 Item 3)
7	-	Pinch Shaft (P/O PL 13.1 Item 3)
8	-	Pinch Spring (P/O PL 13.1 Item 3)
9	-	Pinch Roll (P/O PL 13.1 Item 3)
10	-	MSI Front Handle (P/O PL 13.1 Item 1)
11	-	MSI Lower Assembly (P/O PL 13.1 Item 1)
12	120E32540	Actuator
13	050K67000	MSI Front Handle (REF: PL 13.3)
14	-	INST Label (P/O PL 13.1 Item 19)
15	-	Max Label (P/O PL 13.1 Item 19)
16	-	MSI Front Cover (Not Spared)
17	-	Number Label (Not Spared)
18	-	MSI Rear Cover (Not Spared)
19	604K68210	Label Kit (Includes Items 14, 15)

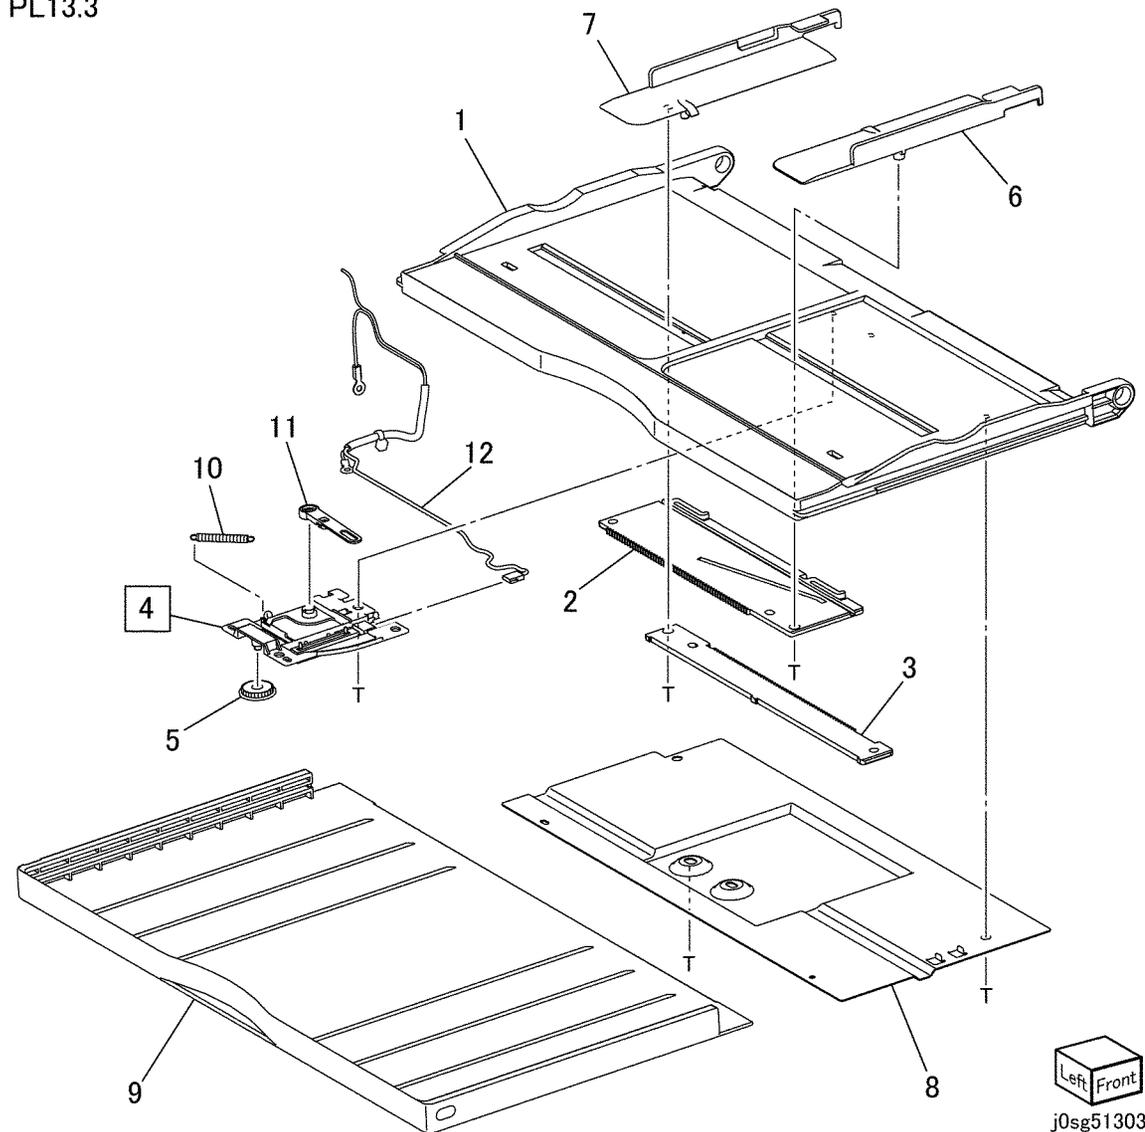
PL 13.3 MSI Tray Assembly

Item	Part	Description
1	-	MSI Tray (Not Spared)
2	-	Front Rack (Not Spared)
3	-	Rear Rack (Not Spared)
4	-	MSI Paper Size Sensor Assembly (Not Spared)
5	-	Pinion Gear (Not Spared)
6	-	Front Side Guide (Not Spared)
7	-	Rear Side Guide (Not Spared)
8	-	Tray Cover (Not Spared)
9	-	Extension Tray (Not Spared)
10	-	Spring (Not Spared)
11	-	Sensor Link (Not Spared)
12	-	Harness (Not Spared)

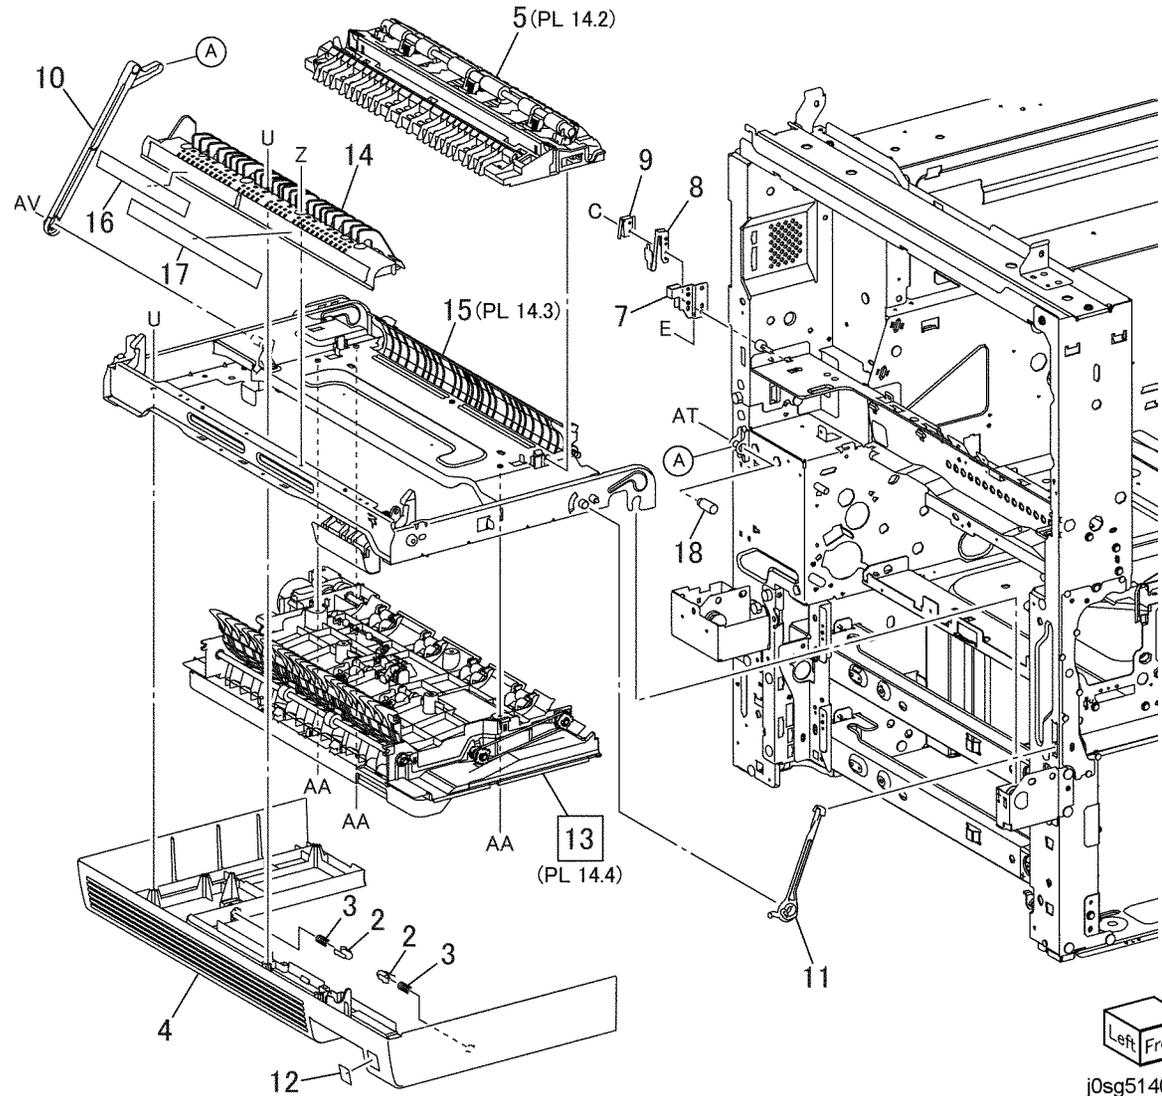
PL 14.1 L/H Cover Assembly, Duplex Unit

Item	Part	Description
1	848K47760	Cover Kit (Includes Items 2, 3, 4)
2	803E06340	Tray Lock
3	809E91630	Spring
4	848K47770	L/H Cover
5	054K46020	L/H Chute Assembly (REF: PL 14.2)
6	110K16600	L/H Cover Interlock Assembly (Includes Items 7-9)
7	—	Bracket (P/O PL 14.1 Item 6)
8	—	Switch Plate (P/O PL 14.1 Item 6)
9	—	Interlock Switch (P/O PL 14.1 Item 6)
10	849E95630	Rear L/H Support
11	868E48840	Front L/H Support
12	—	Door Label (P/O PL 14.1 Item 15)
13	059K71300	Duplex Assembly (REF: PL 14.4)
14	054E46391	L/H Chute Cover
15	801K47070	L/H Frame (REF: PL 14.3)
16	—	L/H Label (FX) (Not Spared)
17	—	Label (Not Spared)
18	—	Shaft (Not Spared)
19	—	L/H Cover Assembly (Not Spared) (Includes Items 1-5, 10-15)

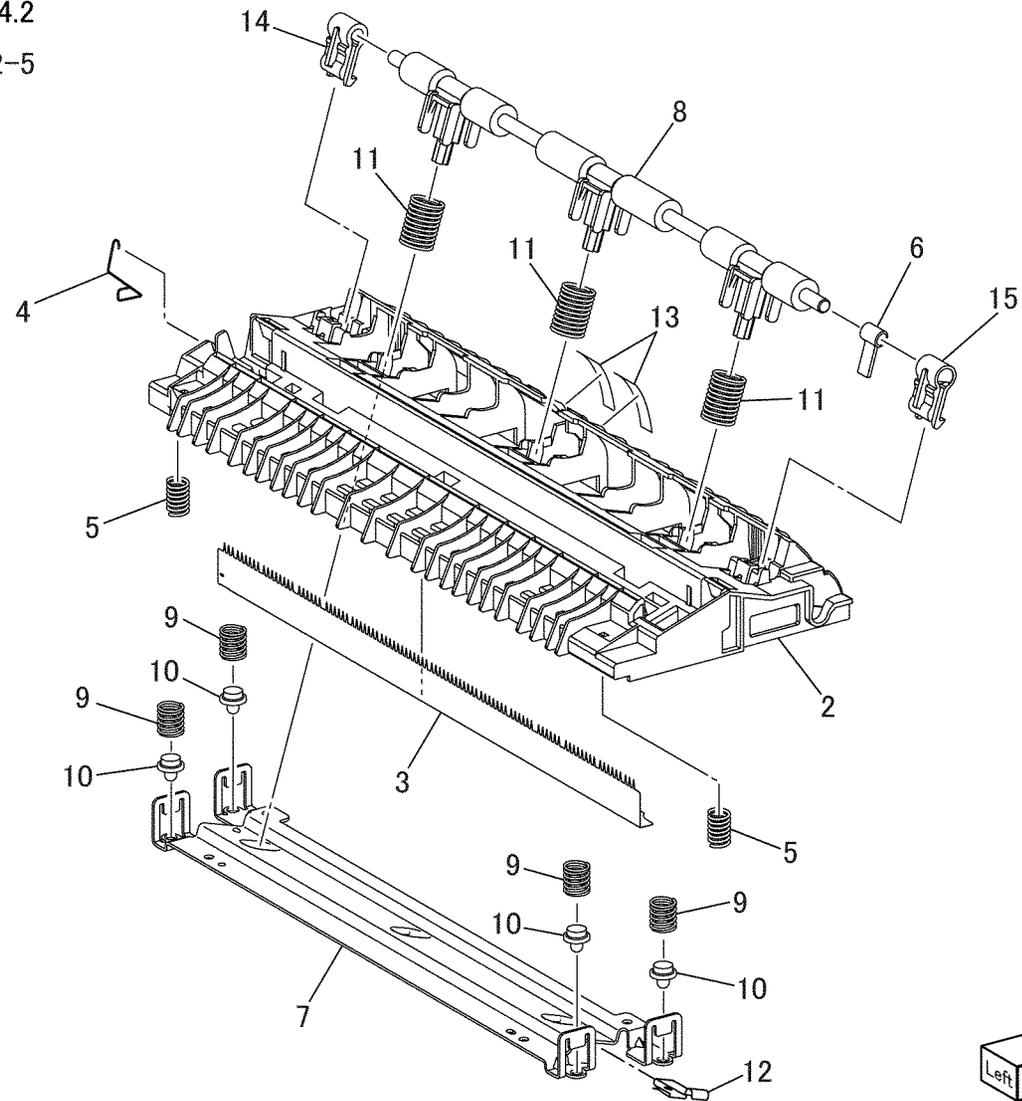
PL 14.2 L/H Chute Assembly

Item	Part	Description
1	-	BTR Chute Assembly (Not Spared) (Includes Items 2-5)
2	-	BTR Chute (P/O PL 14.2 Item 1)
3	-	Detack Saw (P/O PL 14.2 Item 1)
4	-	DTS Contact Spring (P/O PL 14.2 Item 1)
5	-	Spring (P/O PL 14.2 Item 1)
6	-	Bearing (Not Spared)
7	-	Tie Plate (Not Spared)
8	-	Registration Roll Assembly (Not Spared)
9	-	Spring (Not Spared)
10	-	Guide (Not Spared)
11	-	Pinch Spring (Not Spared)
12	-	Earth Plate (Not Spared)
13	-	Chute Guide (Not Spared)
14	-	Rear Holder (Not Spared)
15	-	Front Holder (Not Spared)

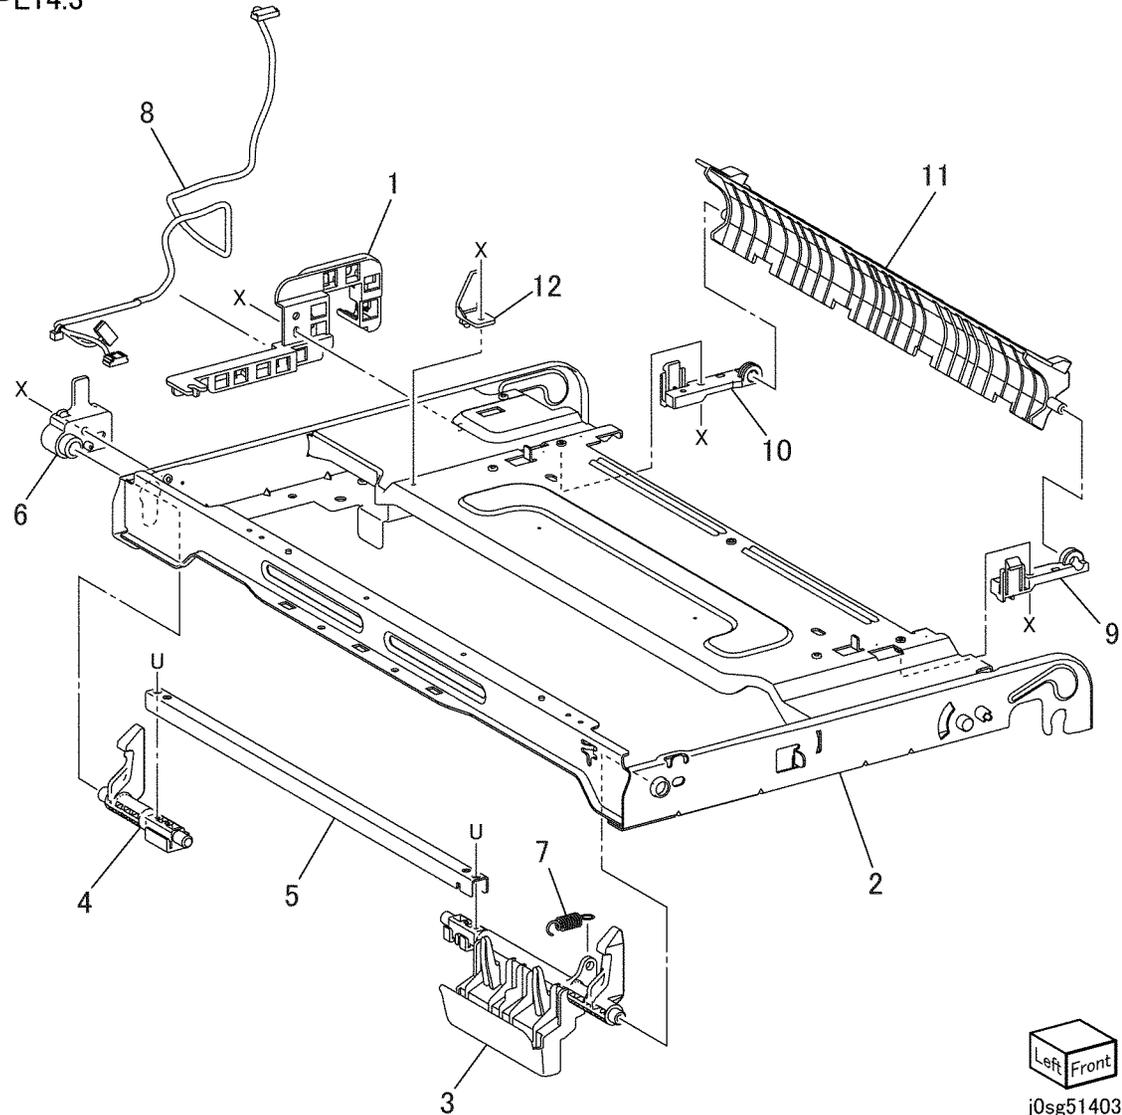
PL 14.3 L/H Frame Assembly

Item	Part	Description
1	-	Harness Guide (Not Spared)
2	-	L/H Frame (Not Spared)
3	011E25180	Front Latch Lever
4	011E24180	Rear Latch Lever
5	-	Latch Plate (Not Spared)
6	120E33110	Actuator
7	-	Spring (Not Spared)
8	-	Harness (Not Spared)
9	-	Front BTR Chute Lock (Not Spared)
10	-	Rear BTR Chute Lock (Not Spared)
11	-	Duplex Lower Chute (Not Spared)
12	024E04380	CRU Shutter Rod

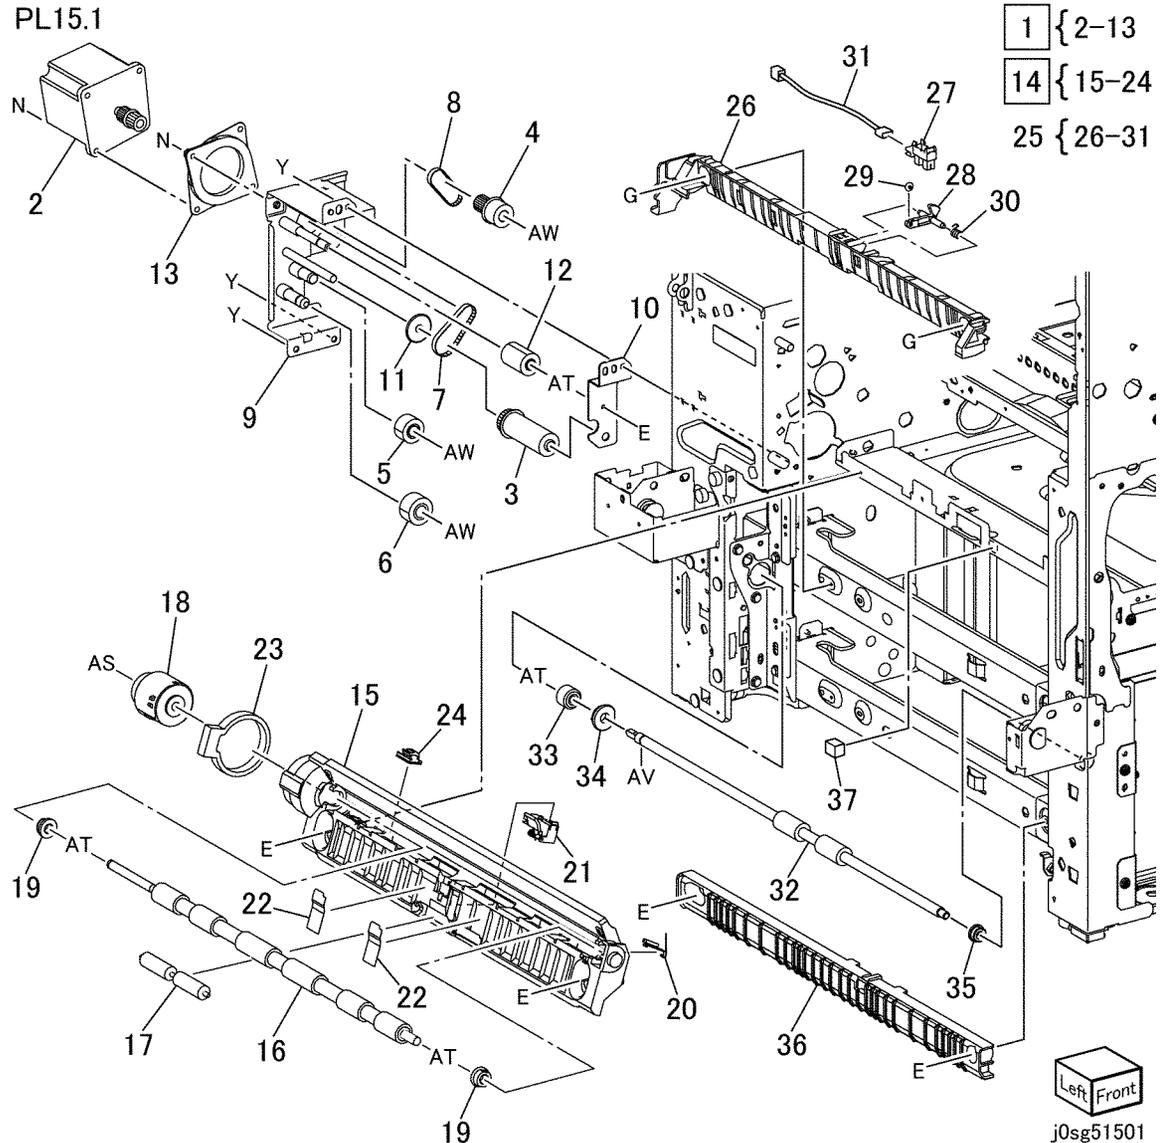
PL 15.1 Registration (1of2)

Item	Part	Description
1	127K63910	Takeaway Motor Assembly (Includes Items 2-13) (REP 8.7)
2	-	Takeaway Motor (P/O PL 15.1 Item 1)
3	-	Gear/Pulley (19T/29T) (P/O PL 15.1 Item 1)
4	-	Gear/Pulley (20T/20T) (P/O PL 15.1 Item 1)
5	-	Gear (20T) (P/O PL 15.1 Item 1)
6	-	Gear (23T) (P/O PL 15.1 Item 1)
7	-	Belt (P/O PL 15.1 Item 1)
8	-	Belt (P/O PL 15.1 Item 1)
9	-	Bracket (P/O PL 15.1 Item 1)
10	-	Gear Bracket (P/O PL 15.1 Item 1)
11	-	Collar (P/O PL 15.1 Item 1)
12	-	Gear (19T) (P/O PL 15.1 Item 1)
13	-	Motor Damper (P/O PL 15.1 Item 1)
14	059K71651	Registration Transport Assembly (Includes Items 15-24) (REP 10.12)
15	-	Registration Chute (P/O PL 15.1 Item 14)
16	-	Registration Roll Assembly (P/O PL 15.1 Item 14)
17	-	Idler Roller (P/O PL 15.1 Item 14)
18	121K37450	Registration Clutch Assembly
19	-	Bearing (P/O PL 15.1 Item 14)
20	-	Earth Plate (P/O PL 15.1 Item 14)
21	130K64270	Registration Sensor
22	-	Paper Guide (P/O PL 15.1 Item 14)

23	-	Seal (P/O PL 15.1 Item 14)
24	-	Clamp (P/O PL 15.1 Item 14)
25	054K46431	Takeaway Chute Assembly (Includes Items 26-31)
26	-	Takeaway Chute (P/O PL 15.1 Item 25)
27	930W00113	Feed Out Sensor and Bracket (Includes Items 14, 15)
28	-	Actuator (P/O PL 15.1 Item 25)
29	059E98780	Actuator Roller
30	-	Spring (P/O PL 15.1 Item 25)
31	-	Wire Harness (P/O PL 15.1 Item 25)
32	059K71200	Takeaway Roller 2
33	807E35950	Gear (18T)
34	013E39690	Bearing
35	-	Bearing (Not Spared)
36	054E46260	Lower Chute
37	-	Block (Not Spared)

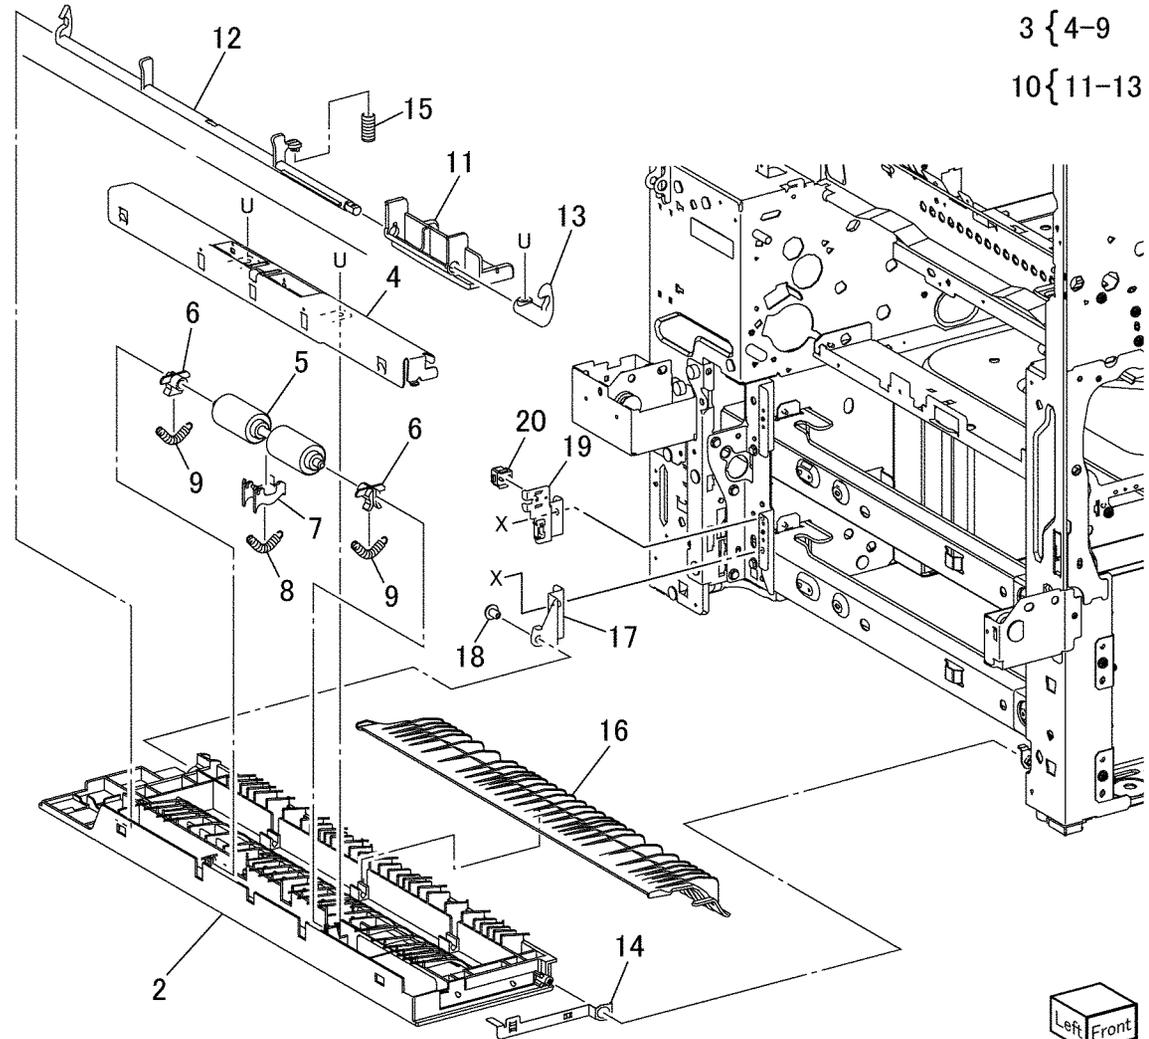
PL 15.2 Registration (2of2)

Item	Part	Description
1	848K47660	Left Lower Chute Cover Assembly (Includes Items 2-16)
2	-	Left Lower Chute Cover (P/O PL 15.2 Item 1)
3	-	L/H Bracket Assembly (P/O PL 15.2 Item 1) (Includes Items 4-9)
4	-	L/H Lower Chute (P/O PL 15.2 Item 3)
5	-	Pinch Roller (P/O PL 15.2 Item 3)
6	-	Bearing (P/O PL 15.2 Item 3)
7	-	Bearing (P/O PL 15.2 Item 3)
8	-	Spring (P/O PL 15.2 Item 3)
9	-	Spring (P/O PL 15.2 Item 3)
10	-	L/H Lower Handle Assembly (P/O PL 15.2 Item 1) (Includes Items 11-13)
11	-	L/H Lower Handle (P/O PL 15.2 Item 10)
12	-	Shaft (P/O PL 15.2 Item 10)
13	-	Front Hook (P/O PL 15.2 Item 10)
14	-	Earth Plate (P/O PL 15.2 Item 1)
15	-	Spring (P/O PL 15.2 Item 1)
16	-	L/H Lower Inner Chute (P/O PL 15.2 Item 1)
17	-	Bracket (Not Spared)
18	-	Rivet (Not Spared)
19	-	Bracket (Not Spared)
20	110E11580	L/H Lower Cover Interlock Switch

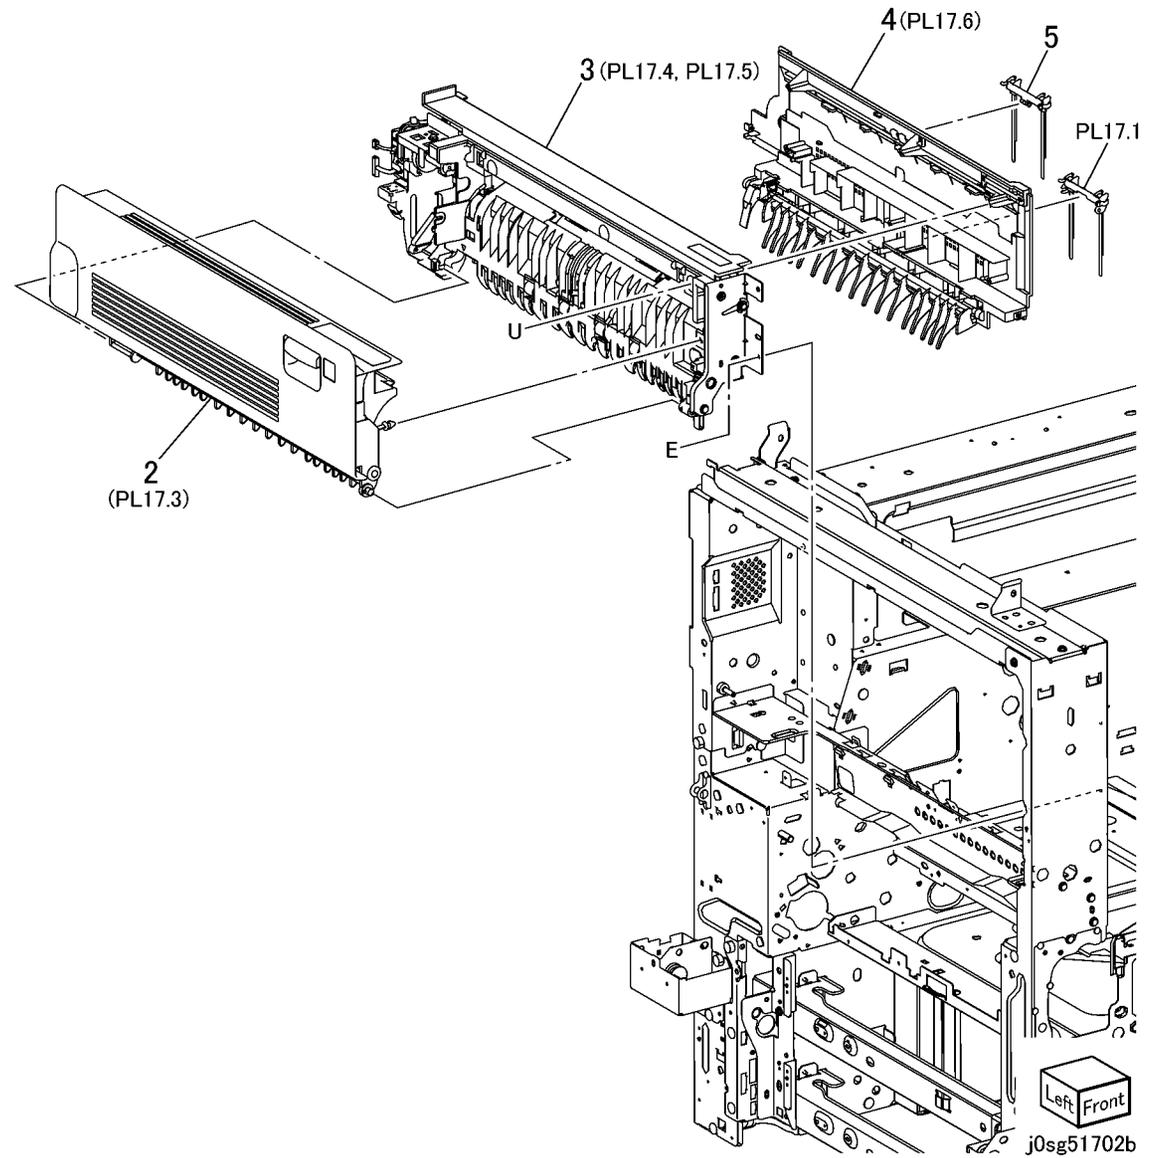
PL 17.2 Exit 2

Item	Part	Description
1	059K71290	Left Upper Cover
2	–	Exit 2 Chute Assembly (REF: PL 17.3)
3	–	Exit 2 Transport and Bracket Assemblies (REF: PL 17.4, PL 17.5)
4	038K20750	Exit 2 Guide Assembly (REF: PL 17.6) (REP 10.5)
5	036K92050	Paper Weight

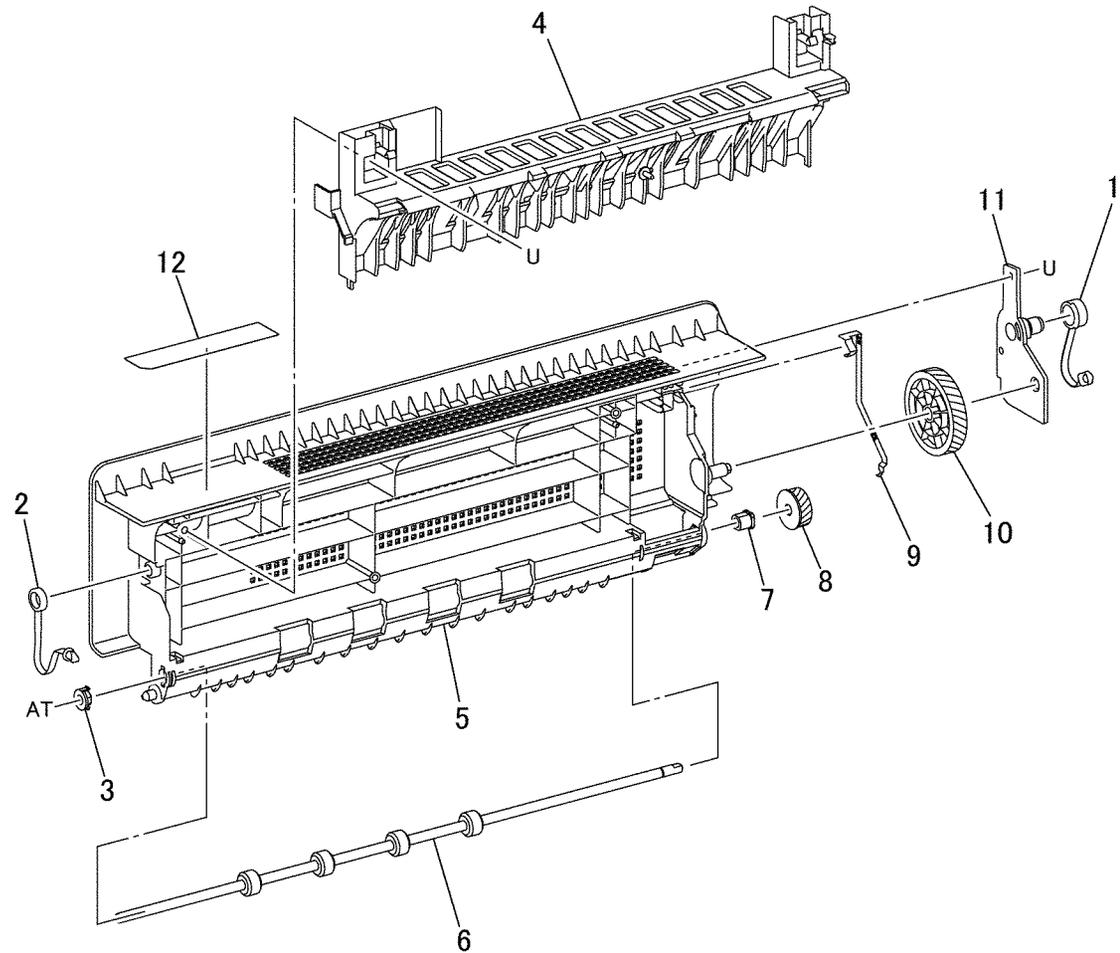
PL 17.3 Exit 2 Chute Assembly

Item	Part	Description
1	003E75360	Exit 2 Rear Stopper
2	003E76760	Exit 2 Front Stopper
3	-	Bearing (Not Spared)
4	-	Exit 2 Chute (Not Spared)
5	-	L/H High Chute (Not Spared)
6	059K53741	Inverter Roller
7	-	Sleeve Bearing (Not Spared)
8	-	Gear (22T) (Not Spared)
9	-	Earth Plate (Not Spared)
10	-	Gear (52T) (Not Spared)
11	-	Gear Cover (Not Spared)
12	-	Caution Label (Not Spared)

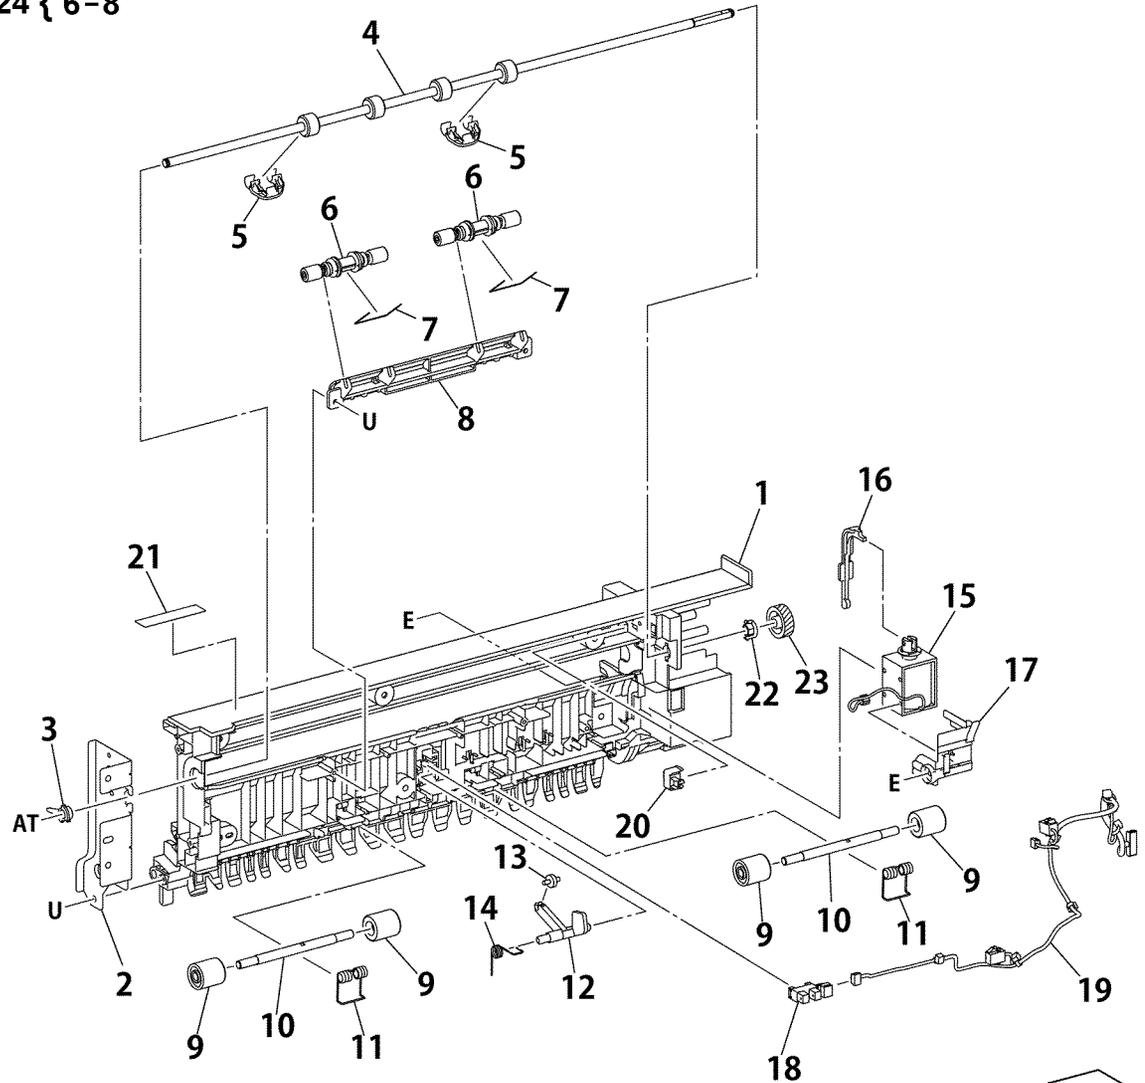
PL 17.4 Exit 2 Transport Assembly (1of2)

Item	Part	Description
1	-	Lower 2 Chute (Not Spared) (REP 10.5)
2	-	Bracket (Not Spared)
3	013E33410	Bearing
4	059K66230	Exit 2 Roller
5	055E57522	Exit Guard
6	-	Exit Pinch Roller (P/O PL 17.4 Item 24)
7	-	Exit Pinch Spring (P/O PL 17.4 Item 24)
8	-	Exit Chute (P/O PL 17.4 Item 24)
9	-	Inverter Pinch Roll (Not Spared)
10	-	Inverter Pinch Shaft (Not Spared)
11	809E75460	Spring
12	120E29430	Actuator
13	059E98780	Actuator Roller
14	809E37332	Spring
15	921W11601	Exit Gate Solenoid (REP 10.7)
16	-	Exit Gate Link (Not Spared)
17	-	Solenoid Cover (Not Spared)
18	930W00123	Exit 2 Sensor (REP 10.7)
19	-	Wire Harness (Not Spared)
20	110E11580	L/H High Chute Interlock Switch
21	-	Label (Not Spared)
22	-	Bearing (Not Spared)
23	807E31000	Gear 22T
24	059K73820	Exit Pinch Roll Assembly (Includes Items 6-8)

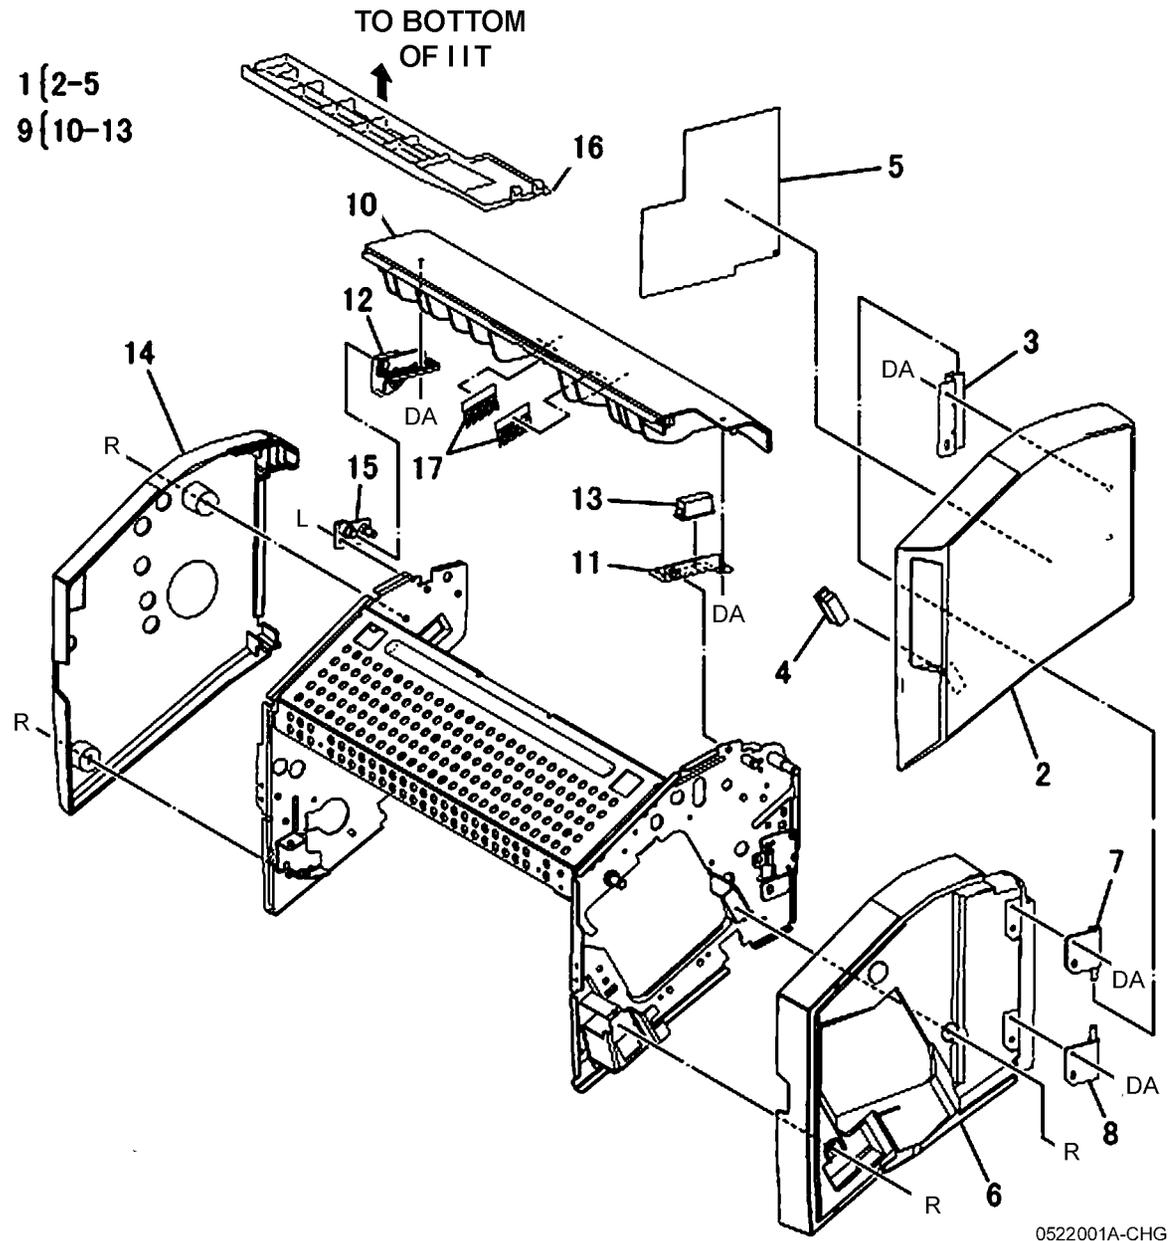
PL 22.1 Finisher Assembly (Part 1 of 2)

Item	Part	Description
1	848K36702	Front Cover Assembly
2	-	Front Cover (P/O PL 22.1 Item 1)
3	-	Bracket (P/O PL 22.1 Item 1)
4	-	Magnet (P/O PL 22.1 Item 1)
5	-	Label (P/O PL 22.1 Item 1)
6	848E50760	Front Inner Cover
7	068K29871	Hinge
8	068K29880	Hinge
9	848K38631	Top Cover Assembly
10	-	Top Cover (P/O PL 22.1 Item 9)
11	-	Bracket (P/O PL 22.1 Item 9)
12	-	Stopper (P/O PL 22.1 Item 9)
13	-	Magnet (P/O PL 22.1 Item 9)
14	848E50790	Rear Cover
15	-	Hinge (Not Spared)
16	815E60280	IIT Cover
17	042E92330	Static Eliminator

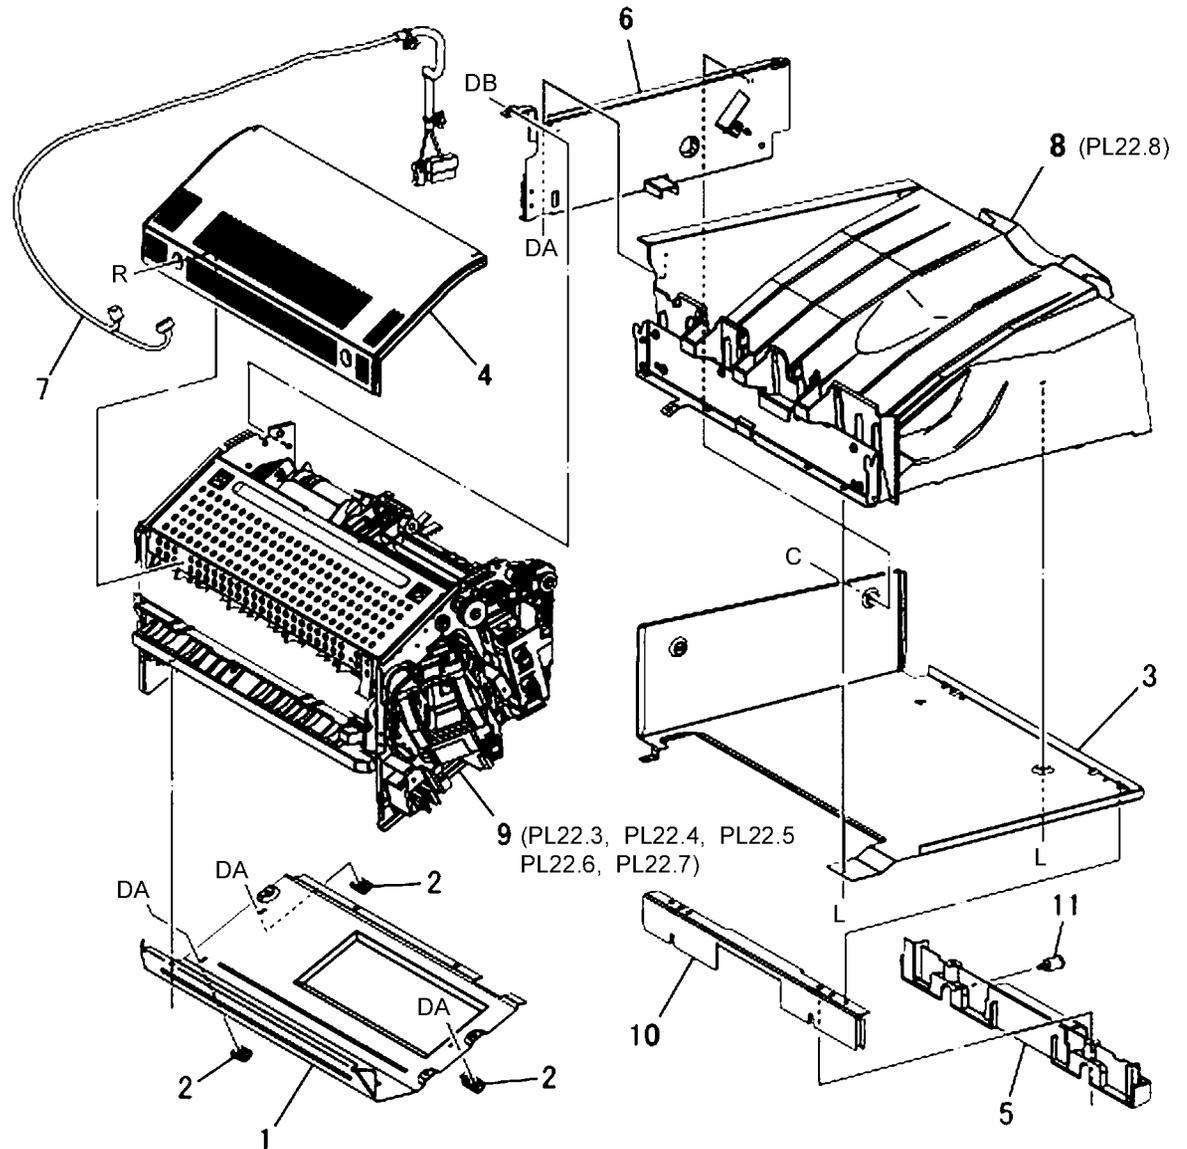
PL 22.2 Finisher Assembly (Part 2 of 2)

Item	Part	Description
1	–	Bottom Cover (Not Spared)
2	–	Spacer (Not Spared)
3	–	Tray Cover (Not Spared)
4	848E50770	Left Cover
5	068K69530	Tray Support
6	–	Rear Bracket (Not Spared)
7	962K42291	Wire Harness
8	050K64830	Stacker Tray Assembly (REP 12.16)
9	–	Stacker Base Assembly (Not Spared)
10	–	Extended Tray Assembly
11	826E24180	Thumb Screw

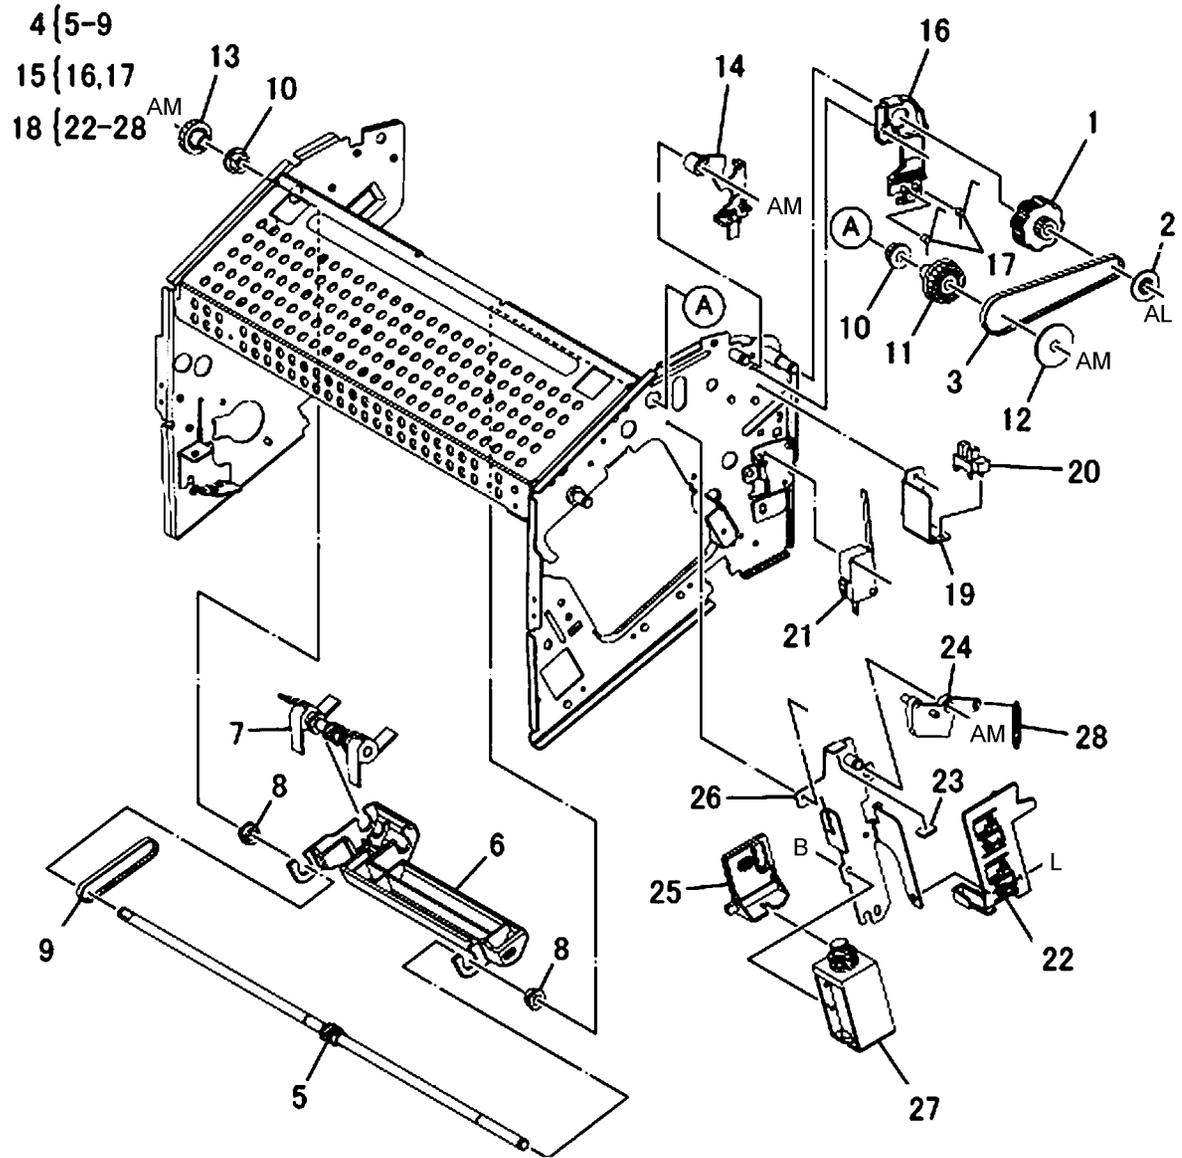
PL 22.3 Stacker Base Assembly (Part 1 of 5)

Item	Part	Description
1	003E65500	Pulley Knob
2	005E89470	Collar
3	423W10454	Paddle Belt (REP 12.2)
4	012K96370	Link Shaft Assembly
5	-	Link Shaft (P/O PL 22.3 Item 4)
6	012E16150	Support
7	-	Sub Paddle Shaft Assembly (P/O PL 22.3 Item 4)
8	-	Bearing (P/O PL 22.3 Item 4)
9	423W06054	Paddle Belt (REP 12.2)
10	413W11860	Bearing
11	020K13900	Pulley
12	005E89490	Collar
13	807E13260	Gear (21T)
14	120E27240	Actuator
15	802K85560	Knob Cover Assembly
16	-	Knob Cover (P/O PL 22.3 Item 15)
17	-	Spring (P/O PL 22.3 Item 15)
18	012K94990	Sub Paddle Solenoid Assembly
19	-	Bracket (Not Spared)
20	130K70160	Finisher Top Cover Interlock Sensor
21	110K12980	Finisher Top Cover Interlock (+24V)
22	-	Support (P/O PL 22.3 Item 18)
23	-	Cushion (P/O PL 22.3 Item 18)
24	-	Link (P/O PL 22.3 Item 18)
25	-	Arm (P/O PL 22.3 Item 18)
26	-	Bracket (P/O PL 22.3 Item 18)
27	121K34620	Sub Paddle Solenoid (REP 12.3)
28	-	Spring (P/O PL 22.3 Item 18)

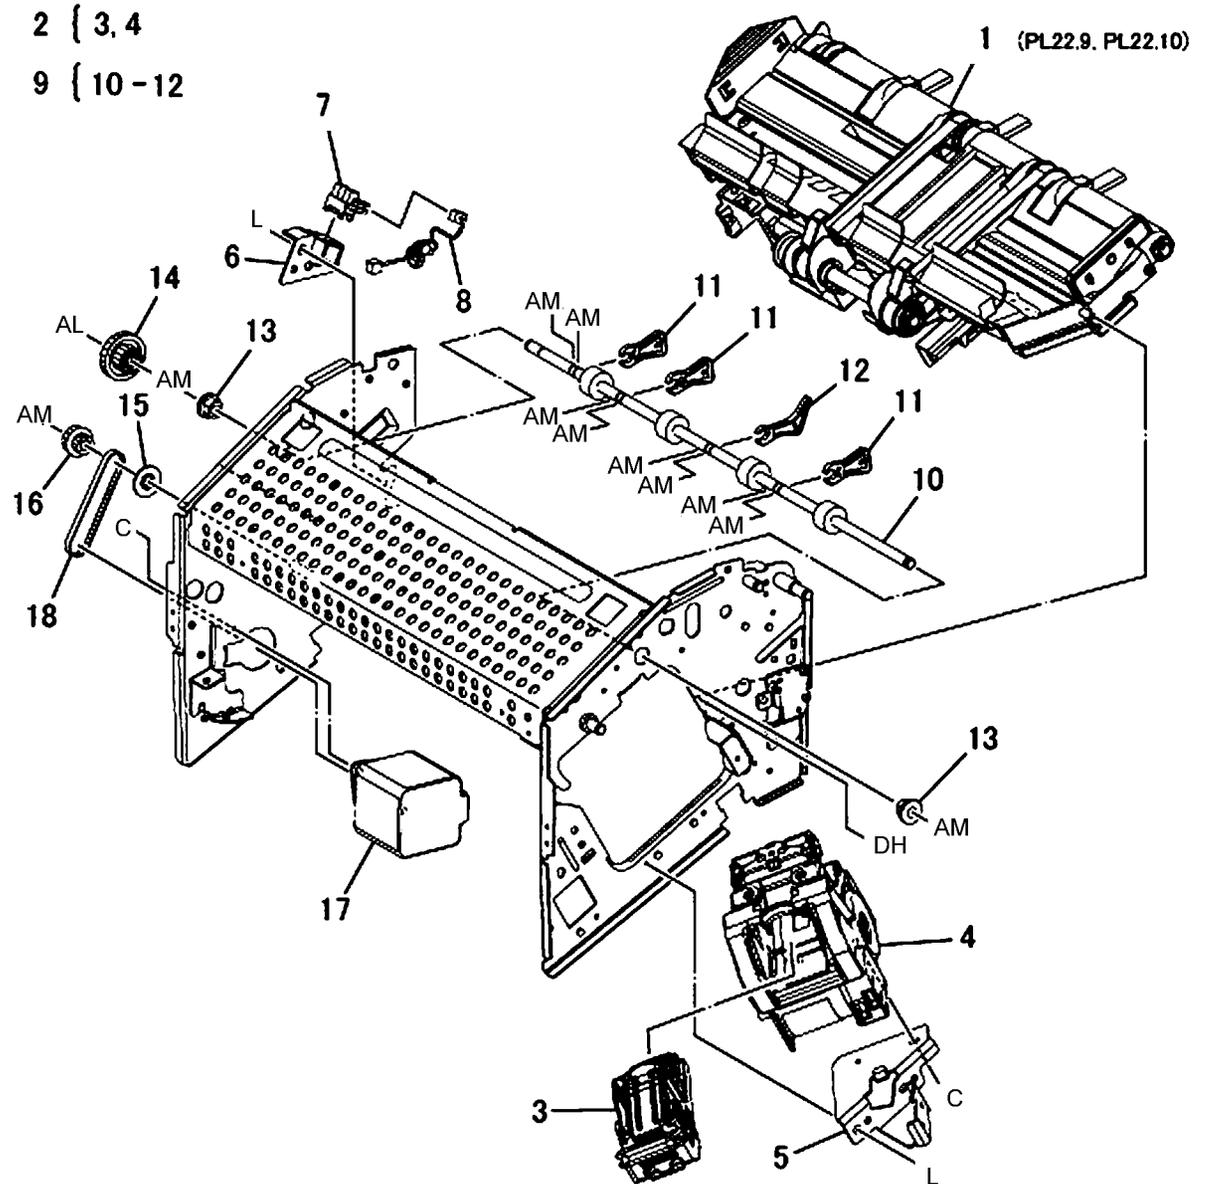
PL 22.4 Stacker Base Assembly (Part 2 of 5)

Item	Part	Description
1	050K65200	Compile Assembly (REP 12.20)
2	029K92350	Staple Assembly (REP 12.5)
3	-	Cartridge (P/O PL 22.4 Item 2)
4	-	Stapler (P/O PL 22.4 Item 2)
5	-	Bracket (Not Spared)
6	-	Support (Not Spared)
7	930W00111	Set Clamp Home Sensor (REP 12.6)
8	962K44980	Wire Harness
9	022K72790	Exit Roll Assembly (REP 12.7)
10	-	Exit Roll (P/O PL 22.4 Item 9)
11	004E15340	Damper
12	004E15330	Center Damper
13	-	Bearing (Not Spared)
14	007K94220	One Way Gear
15	005E89470	Collar
16	807E13230	Gear Pulley (16T/18T)
17	127K49800	Finisher Transport Motor
18	423W06954	Belt

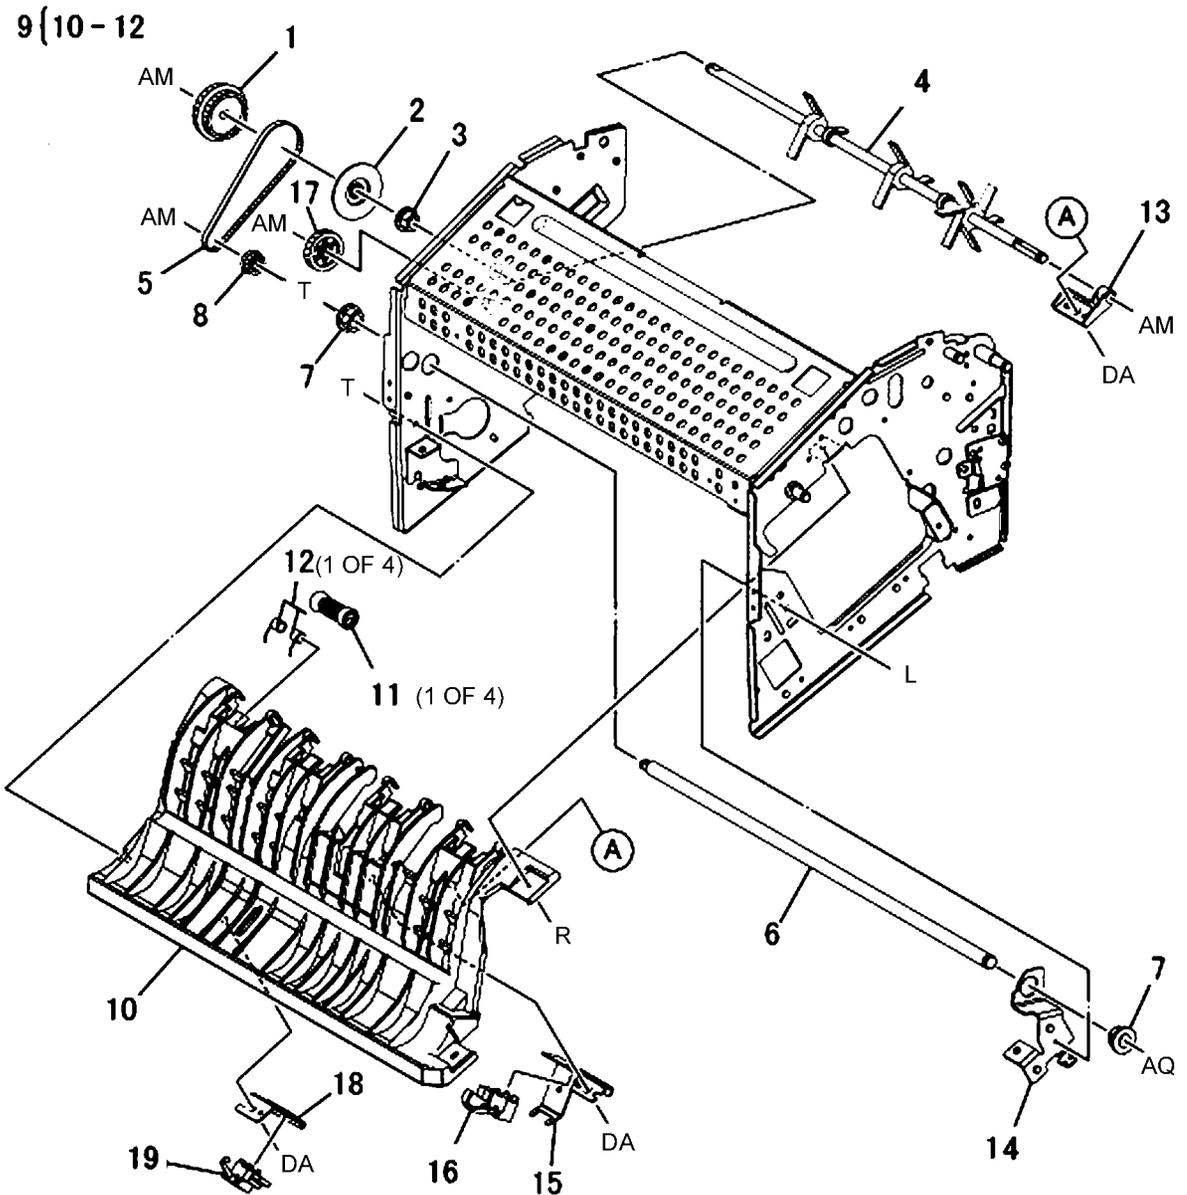
PL 22.5 Stacker Base Assembly (Part 3 of 5)

Item	Part	Description
1	807E13250	Gear Pulley (37T/45T)
2	005E89480	Collar
3	413W75959	Bearing
4	006K25001	Main Paddle Shaft Assembly (REP 12.11)
5	423W09854	Belt
6	-	Shaft (Not Spared)
7	413W77559	Bearing
8	020E43500	Pulley (19T)
9	054K30361	Lower Chute Assembly (REP 12.12)
10	-	Lower Chute (P/O PL 22.5 Item 9)
11	022K73190	Pinch Roll (REP 12.8)
12	809E65931	Spring
13	-	Support (Not Spared)
14	-	Bracket (Not Spared)
15	-	Bracket (Not Spared)
16	130K93251	Compile Exit Sensor (REP 12.10)
17	807E13240	Gear (27T)
18	-	Bracket (Not Spared)
19	130K88190	Finisher Entrance Sensor (REP 12.9)
