WorkCentre 5335 Family Service Documentation

705P01303

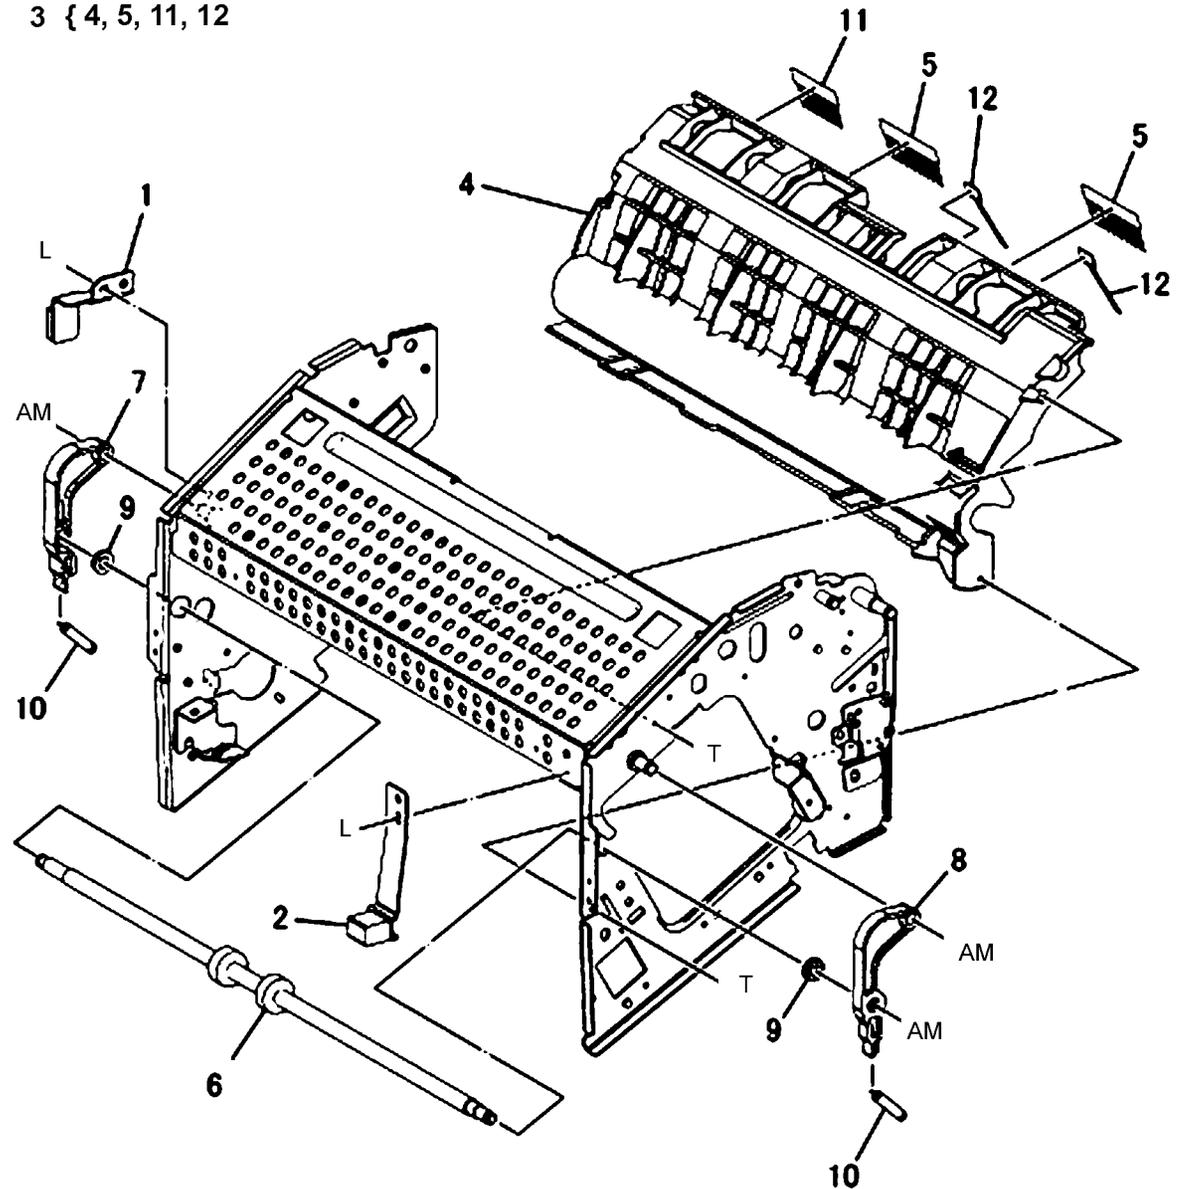
PL 22.6 Stacker Base Assembly (Part 4 of 5)

Item	Part	Description
1	068K29931	Bracket
2	068K29941	Bracket
3	054K42690	Upper Chute Assembly (REP 12.14)
4	-	Upper Chute (P/O PL 22.6 Item 3)
5	042E92241	Eliminator
6	022K72782	Entrance Roll Assembly (REP 12.13)
7	031E97041	Rear Arm
8	031E97020	Front Arm
9	413W66250	Ball Bearing
10	-	Spring (Not Spared)
11	042E92330	Eliminator
12	-	Guide Paper (P/O PL 22.6 Item 3)

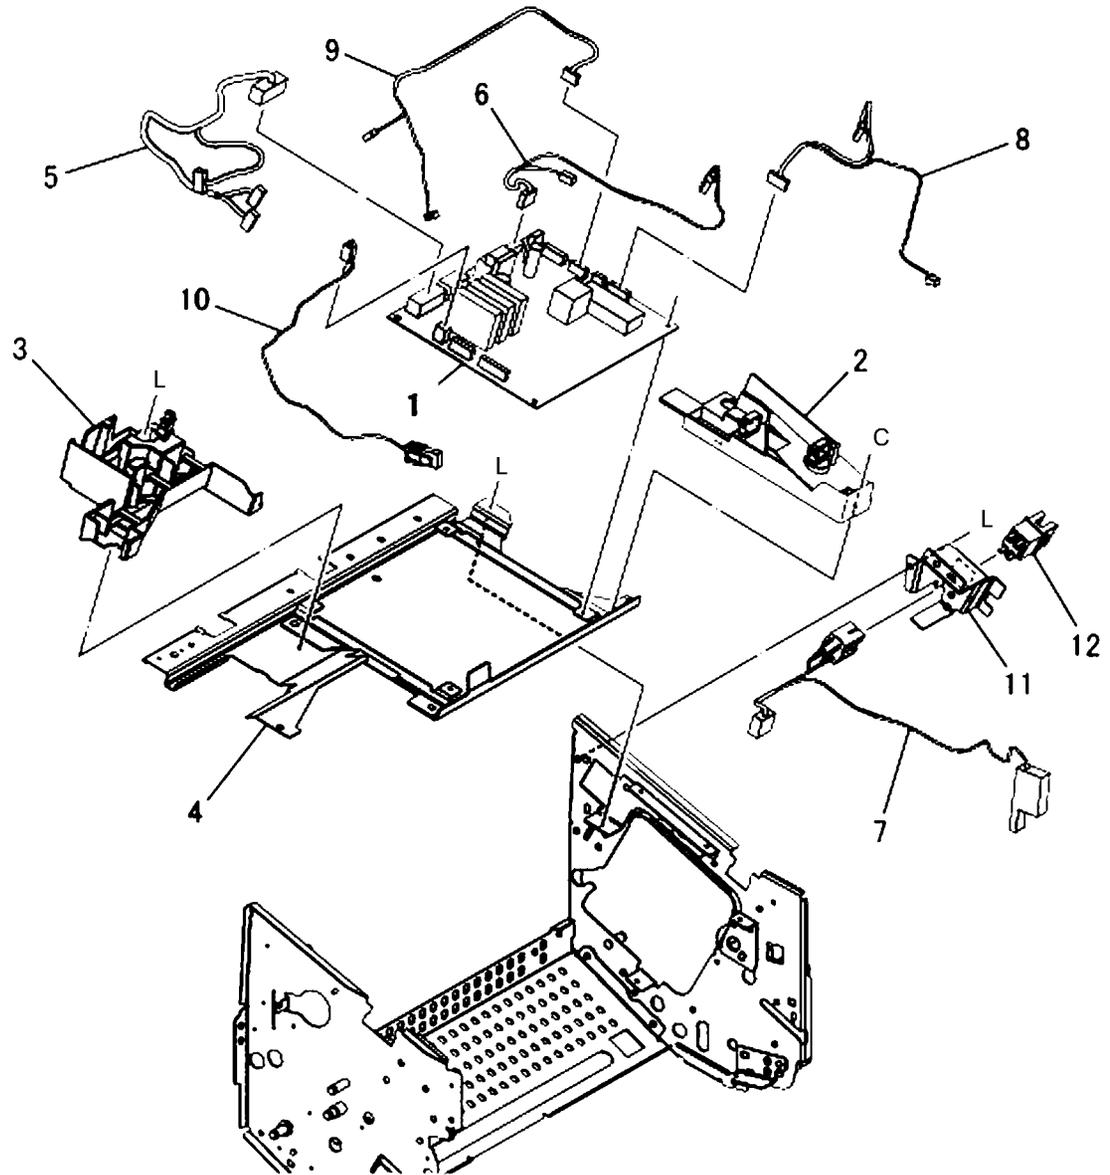
PL 22.7 Stacker Base Assembly (Part 5 of 5)

Item	Part	Description
1	960K50453	Finisher PWB (REP 12.15)
2	055K30850	Connector Bracket
3	—	Harness Guide (Not Spared)
4	—	PWB Bracket (Not Spared)
5	—	Wire Harness (Drive) (Not Spared)
6	—	Wire Harness (Stapler) (Not Spared)
7	—	Wire Harness (Interlock) (Not Spared)
8	—	Wire Harness (Front Sensor) (Not Spared)
9	—	Wire Harness (Compile) (Not Spared)
10	—	Wire Harness (Stacker) (Not Spared)
11	—	Bracket (Not Spared)
12	110E97990	Finisher Front Interlock Switch

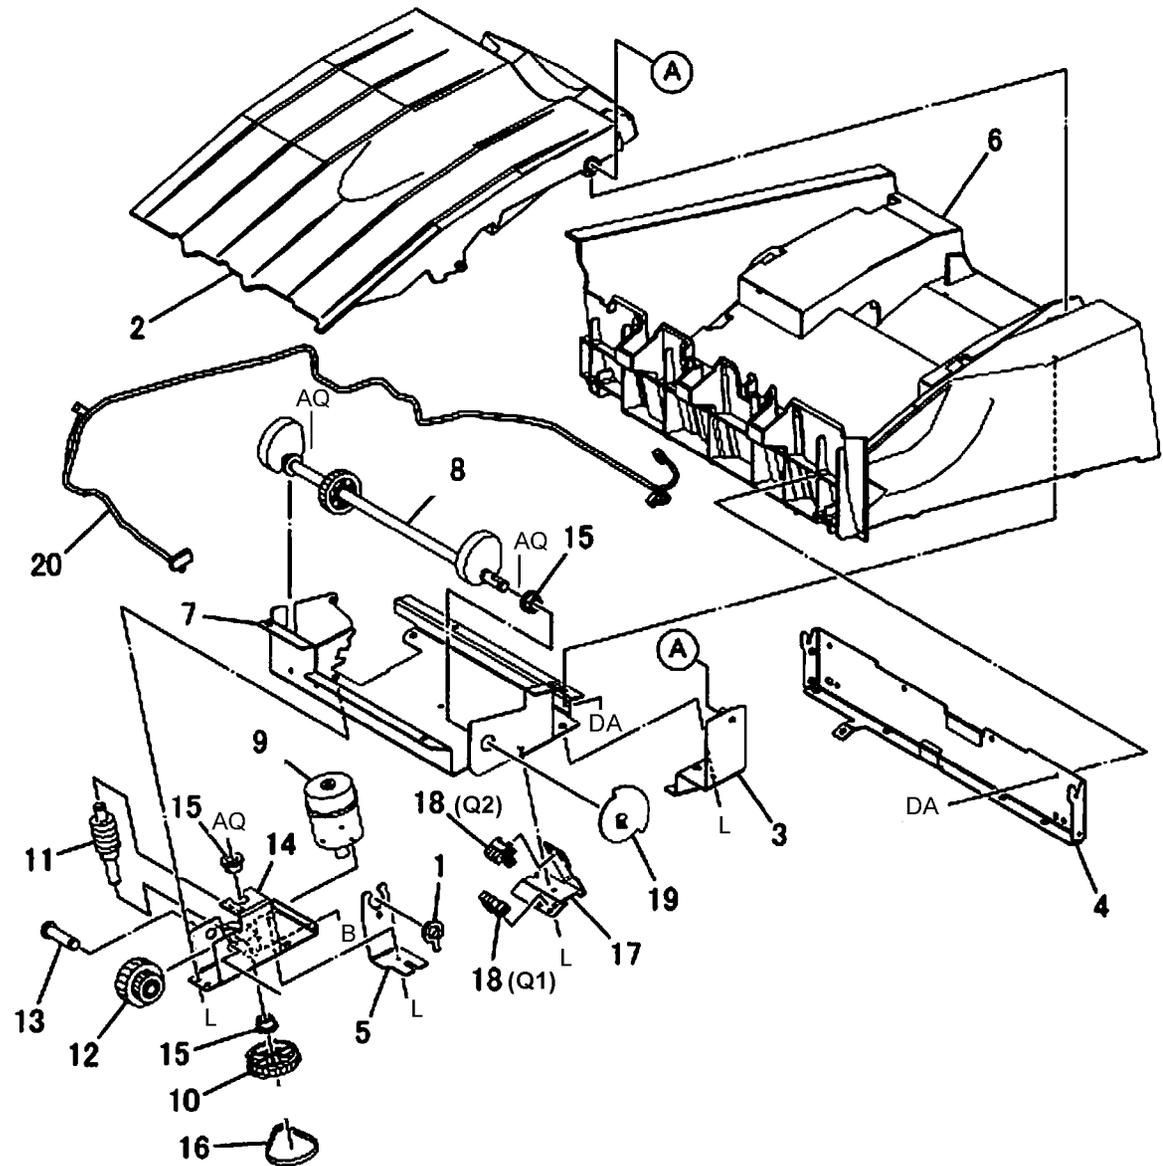
PL 22.8 Stacker Tray Assembly

Item	Part	Description
1	-	Bearing (Not Spared)
2	-	Top Tray (Not Spared) (REP 12.16)
3	-	Bracket (Not Spared)
4	-	Plate (Not Spared)
5	-	Bracket (Not Spared)
6	-	Base Tray (Not Spared)
7	-	Base Bracket (Not Spared)
8	006K25032	Stacker Shaft Assembly (REP 12.17)
9	127K49420	Stacker Motor (REP 12.18)
10	-	Pulley (60T) (Not Spared)
11	-	Worm Gear (Not Spared)
12	-	Gear (16T/32T) (Not Spared)
13	-	Stud (Not Spared)
14	-	Bracket (Not Spared)
15	-	Bearing (Not Spared)
16	423W07354	Belt
17	-	Bracket (Not Spared)
18	930W00111	Stacker Sensor 1 (Q1), Sensor 2 (Q2) (REP 12.19)
19	-	Actuator (Not Spared)
20	-	Wire Harness (Not Spared)

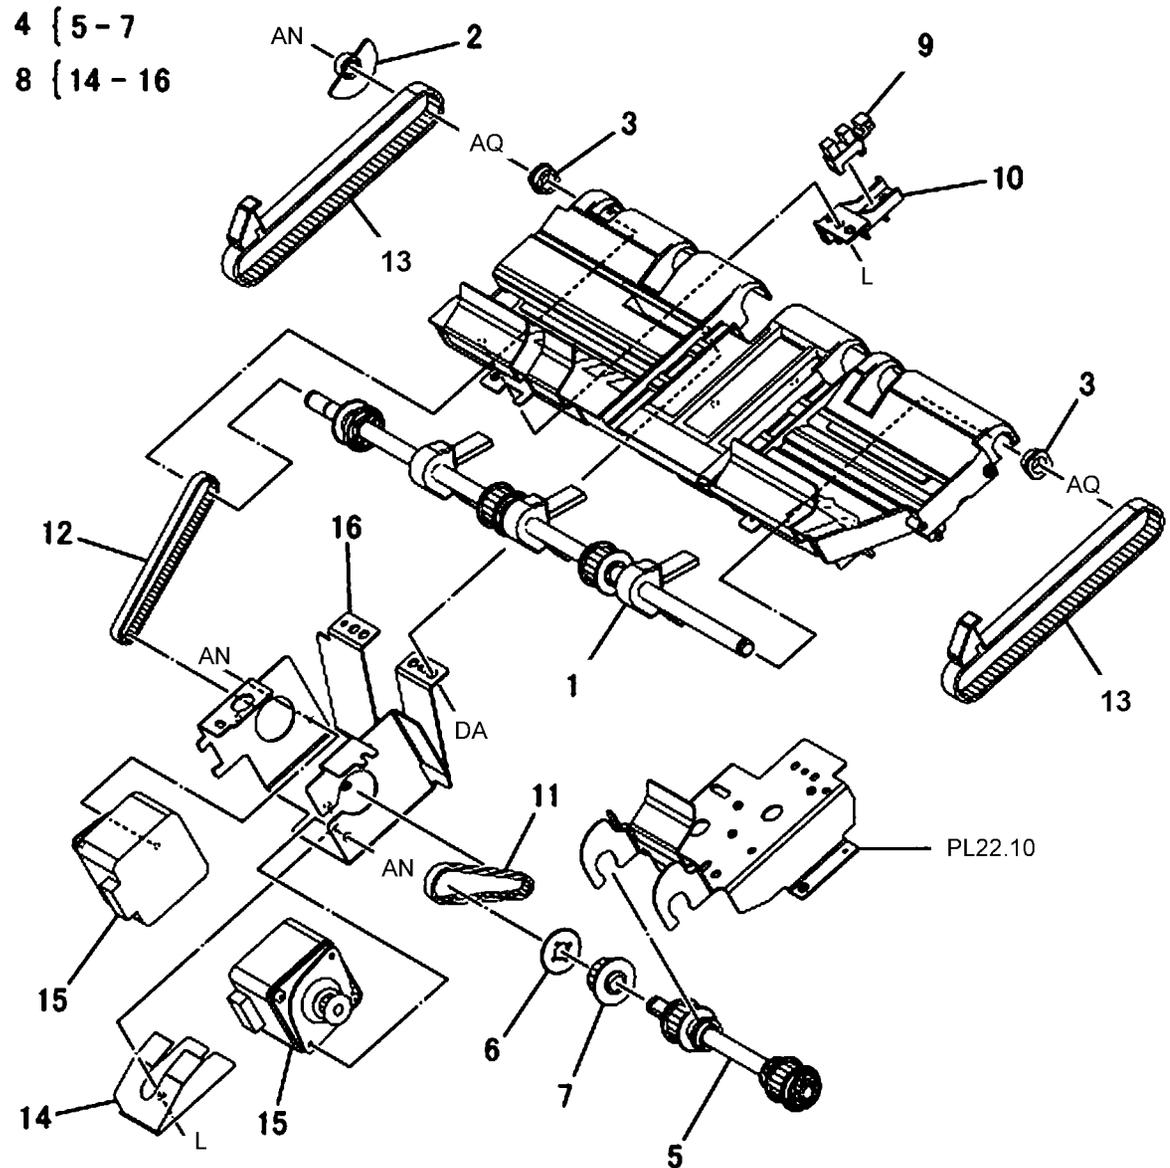
PL 22.9 Compile Assembly (Part 1 of 2)

Item	Part	Description
1	006K25011	Set Clamp Shaft (REP 12.21)
2	120E27220	Actuator
3	413W11860	Bearing
4	006K25020	Eject Shaft Assembly (REP 12.25)
5	-	Eject Shaft (P/O PL 22.9 Item 4)
6	-	Spacer (P/O PL 22.9 Item 4)
7	-	Pulley (P/O PL 22.9 Item 4)
8	068K29830	Eject/Set Clamp Motor Assembly (REP 12.23)
9	930W00111	Rear Tamper Home Sensor (REP 12.24)
10	-	Support (Not Spared)
11	423W26754	Belt
12	423W29454	Belt
13	023K91530	Eject Belt (REP 12.22)
14	-	Spring (P/O PL 22.9 Item 8)
15	-	Eject Motor, Set Clamp Motor (P/O PL 22.9 Item 8)
16	-	Bracket (P/O PL 22.9 Item 8)

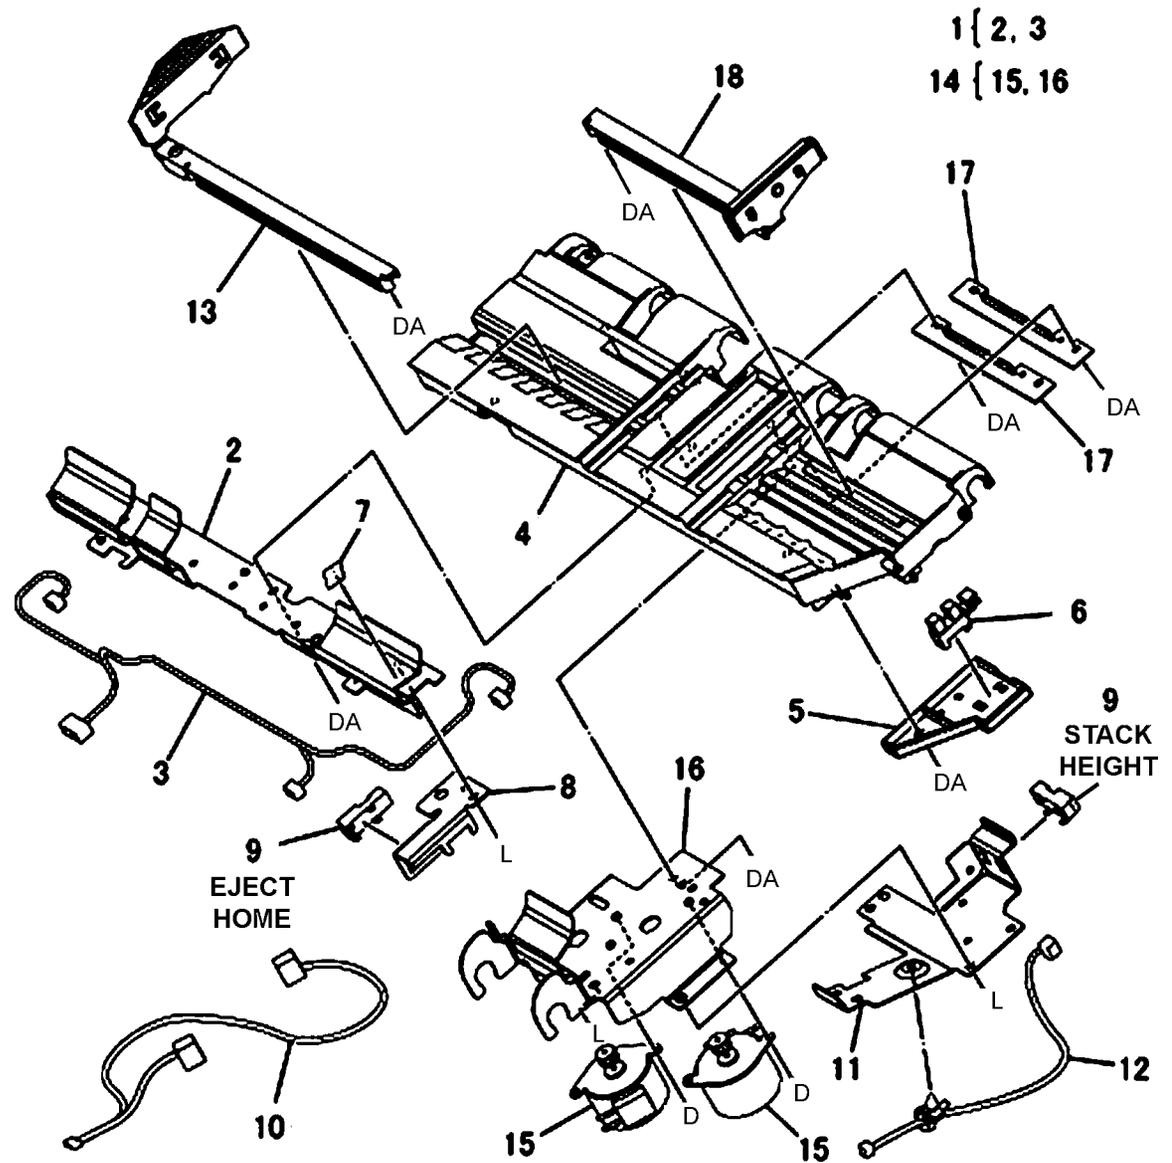
PL 22.10 Compile Assembly (Part 2 of 2)

Item	Part	Description
1	068K30510	Bracket Assembly
2	-	Bracket (P/O PL 22.10 Item 1)
3	-	Wire Harness (P/O PL 22.10 Item 1)
4	050E25900	Compile Tray
5	-	Support (Not Spared)
6	930W00111	Front Tamper Home Sensor (REP 12.27)
7	038E34860	Paper Guide
8	-	Bracket (Not Spared)
9	930W00212	Eject Clamp Home Sensor, Stack Height Sensor (REP 12.28, REP 12.29)
10	962K42270	Wire Harness
11	-	Bracket (Not Spared)
12	-	Wire Harness (Not Spared)
13	038K88990	Tamper Guide, Rear
14	068K30740	Front/Rear Tamper Motor Assembly (REP 12.26)
15	-	Front/Rear Tamper Motor (P/O PL 22.10 Item 14)
16	-	Bracket (P/O PL 22.10 Item 14)
17	001E70981	Rail
18	038K89260	Tamper Guide, Front

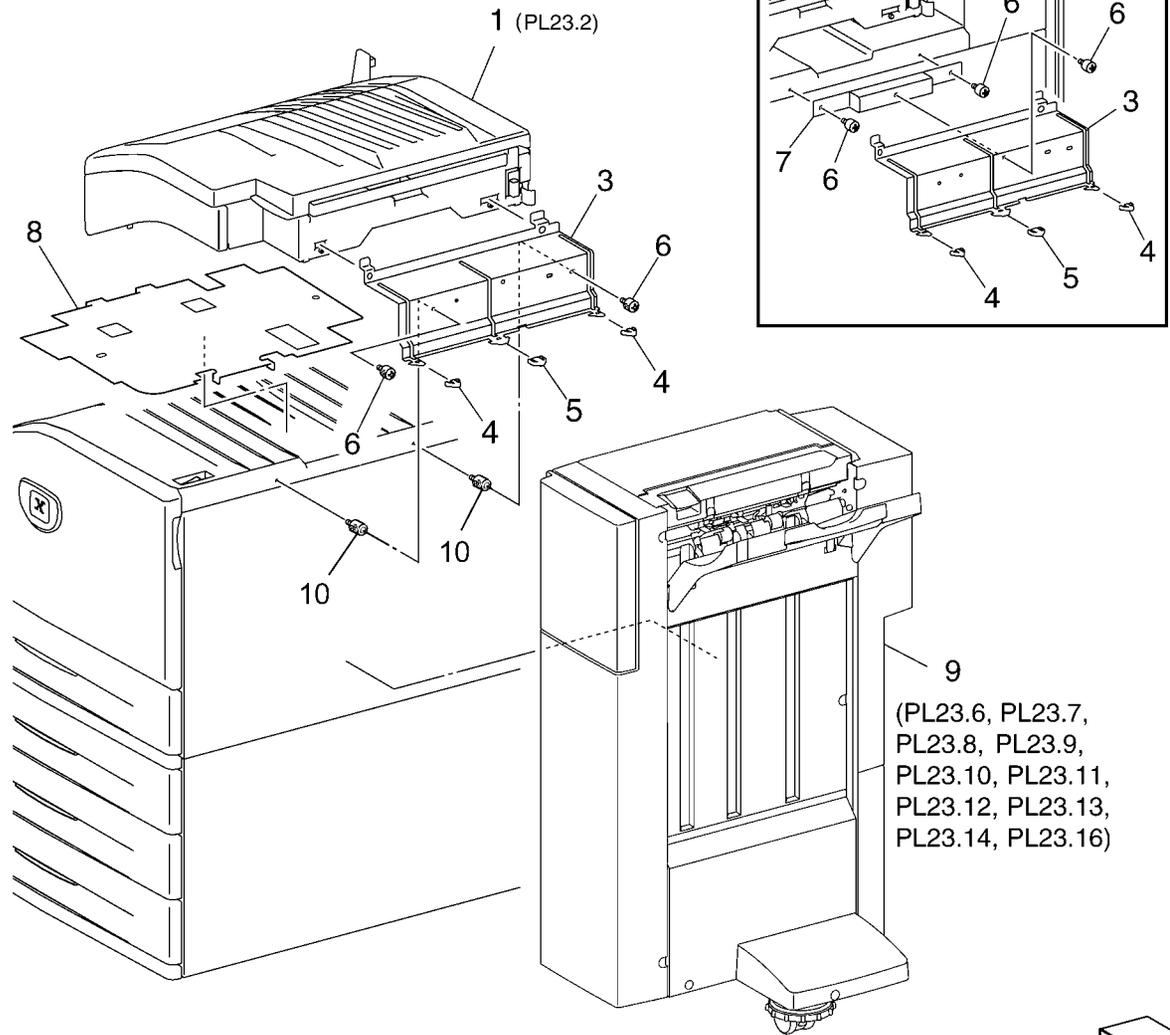
PL 23.1 H - Transport Assembly (1 of 5)

Item	Part	Description
1	059K65560	H-Transport Assembly (REP 13.1)
2	068K59494	Docking Plate Assembly
3	-	Docking Plate (P/O PL 23.1 Item 2)
4	-	Side Guide (P/O PL 23.1 Item 2)
5	-	Center Guide (P/O PL 23.1 Item 2)
6	826E07210	Thumb Screw
7	-	Bracket (P/O PL 23.1 Item 11)
8	-	Finisher Plate
9	-	Finisher LX Assembly (Not Spared)
10	-	HTU Spacer (Not Spared)
11	604K70010	Gap Kit (Includes Items 6, 7 and PL 23.6 Items 18, 19)

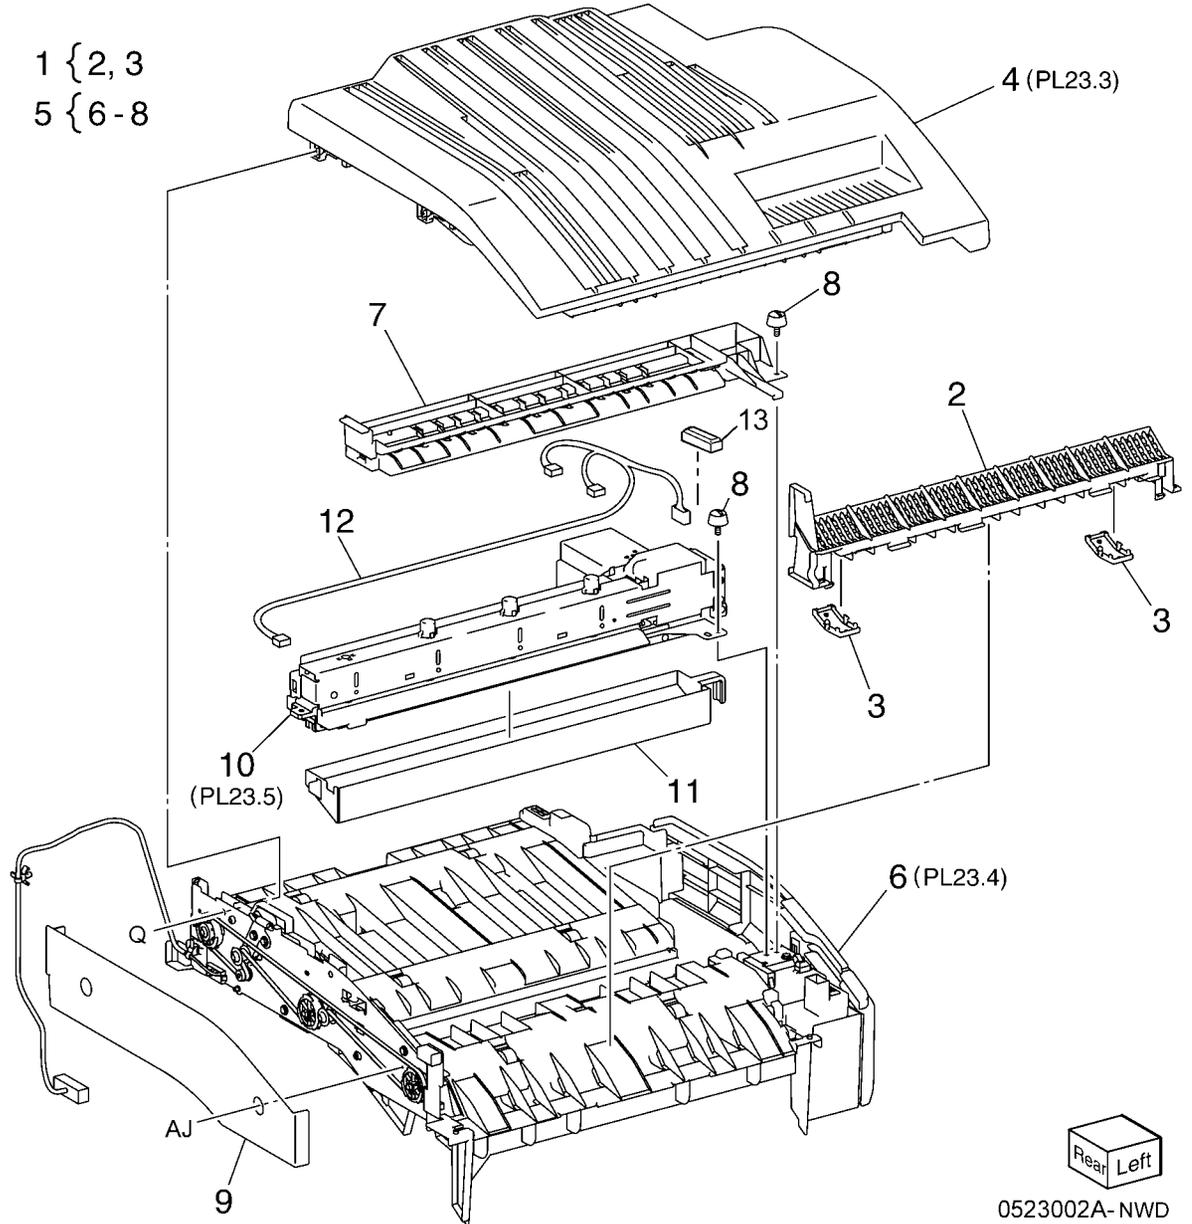
PL 23.2 H - Transport Assembly (2 of 5)

Item	Part	Description
1	848K34181	Left Cover Assembly
2	848E43670	Left Cover
3	-	Paper Guide (P/O PL 23.2 Item 1)
4	848K34170	Top Cover Assembly
5	-	Lower Chute Assembly (P/O PL 23.1 Item 1)
6	-	Lower Chute Assembly (P/O PL 23.2 Item 5)
7	054K35264	Chute Assembly
8	026K81200	Thumb Screw
9	-	Rear Cover (Not Spared)
10	180K00391	Punch Assembly (2/3 Hole) (REP 13.2)
-	180K00401	Punch Assembly (2/4 Hole) (REP 13.2)
11	-	Punch Box (Not Spared)
12	-	Wire Harness (Not Spared)
13	848E28010	Connector Cover

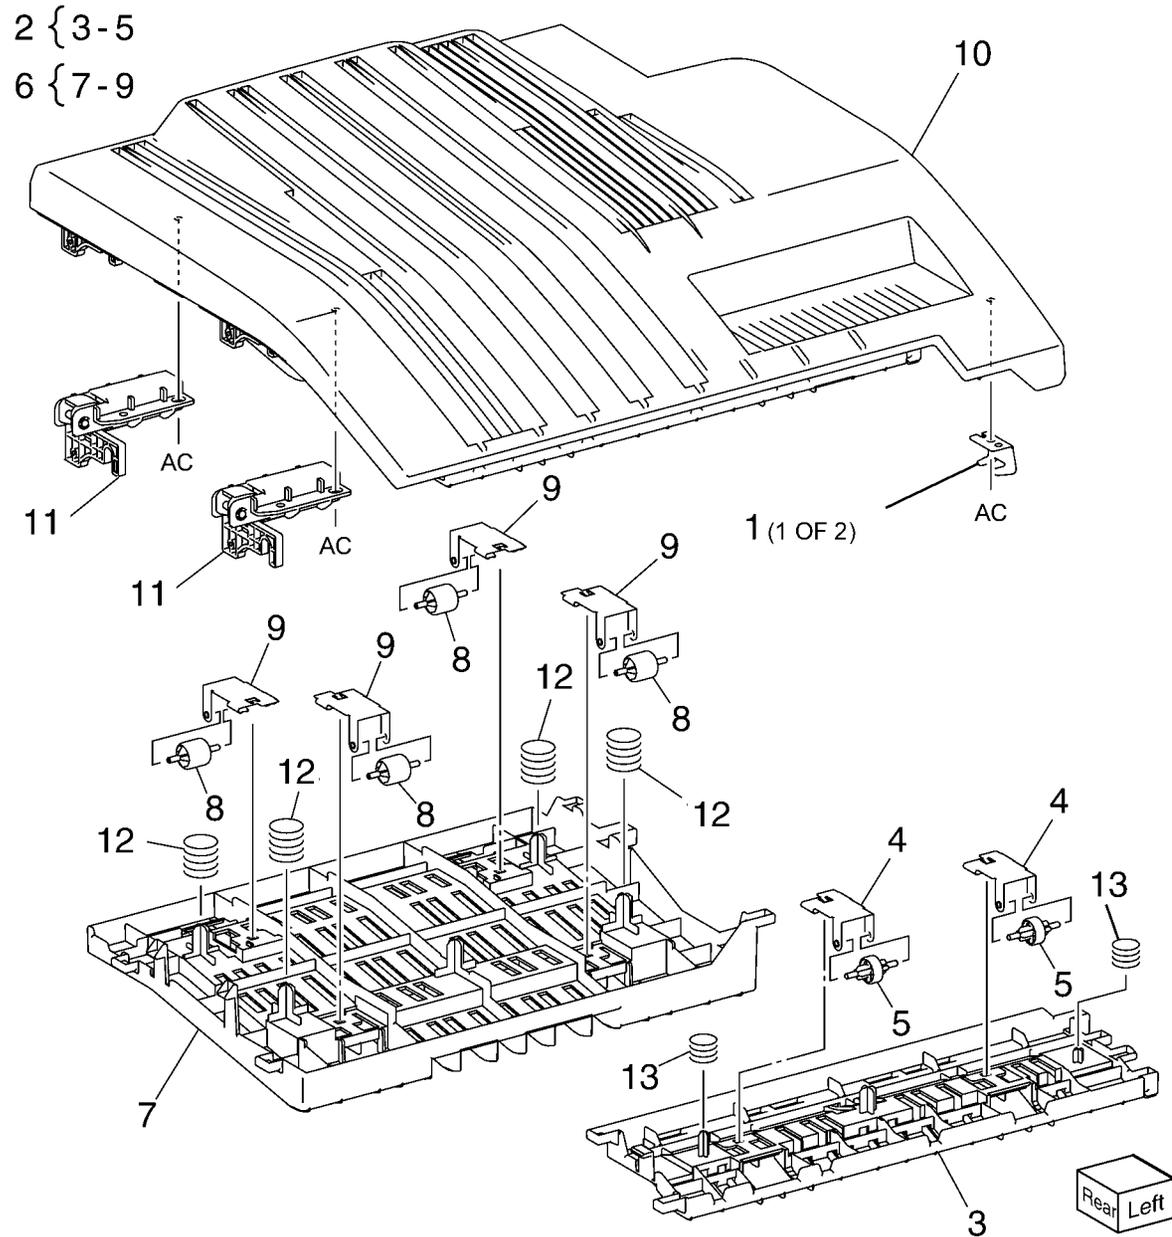
PL 23.3 H - Transport Assembly (3 of 5)

Item	Part	Description
1	-	Bracket (P/O PL 23.2 Item 4)
2	054K35238	Left Chute Assembly
3	-	Left Chute (P/O PL 23.3 Item 2)
4	-	Pinch Spring (P/O PL 23.3 Item 2)
5	-	Pinch Roller (P/O PL 23.3 Item 2)
6	054K35244	Right Chute Assembly
7	-	Right Chute (P/O PL 23.3 Item 6)
8	022E27660	Pinch Roller
9	809E76211	Pinch Spring
10	848E43662	Top Cover
11	003K15984	H - Transport Counter Balance (Left)
12	-	H - Transport Counter Balance (Right) (P/O PL 23.2 Item 4)
13	809E76240	Spring
14	809E78940	Spring

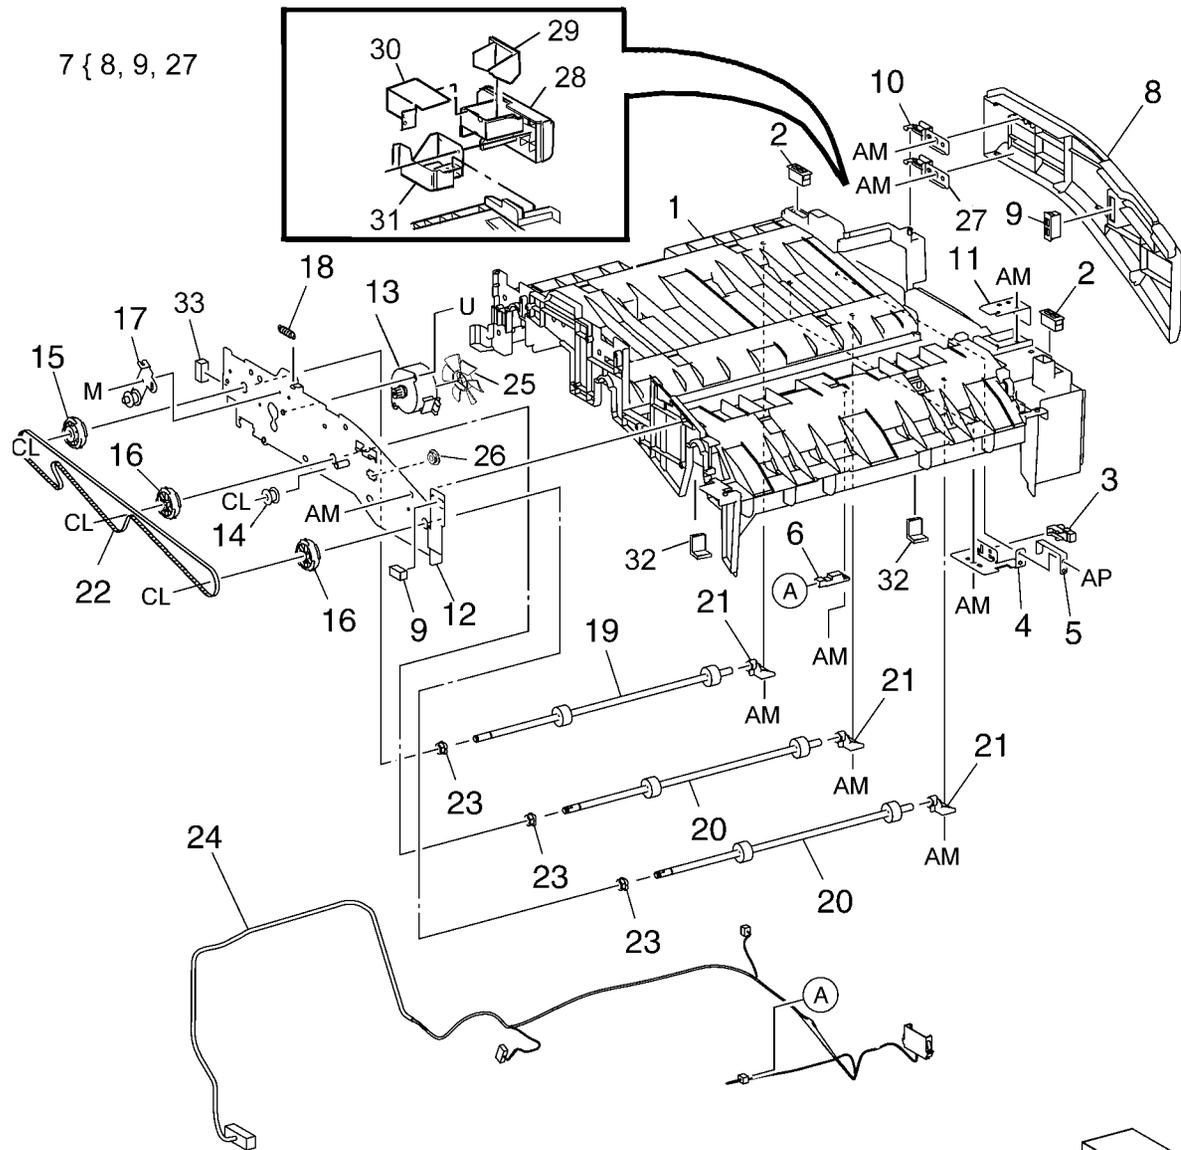
PL 23.4 H - Transport Assembly (4 of 5)

Item	Part	Description
1	-	Lower Chute (P/O PL 23.2 Item 6)
2	-	Magnet (P/O PL 23.2 Item 6)
3	130E81600	H - Transport Open Sensor
4	868E15540	Sensor Bracket
5	809E81720	Actuator
6	930W00211	H - Transport Entrance Sensor
7	848K34192	H - Transport Front Cover Assembly
8	848E43641	H - Transport Front Cover
9	921W41162	Gasket
10	-	Hinge
11	-	Bracket (P/O PL 23.2 Item 6)
12	-	Rear Frame Assembly (P/O PL 23.2 Item 6)
13	127K57622	H - Transport Motor (REP 13.4)
14	020E45330	Tension Pulley
15	020K15720	Pulley (43T)
16	020E45210	Pulley (43T)
17	-	Tension Bracket (P/O PL 23.2 Item 6)
18	809E78950	Spring Tension
19	059K54480	Drive Roll
20	059K55070	Drive Roll
21	013E33140	Bearing
22	423W01154	H - Transport Belt (REP 13.3)
23	413W14660	Sleeve Bearing
24	962K60422	Wire Harness
25	127E85570	Fan Blade
26	016E97311	Pinch Bushing
27	-	Lower Hinge (P/O PL 23.4 Item 7)
28	848E43630	Front Cover
29	848E43651	Switch Cover
30	-	Cover (Not Spared)

31	-	Bracket (Not Spared)
32	004E18112	Pinch Cushion
33	921W41142	Gasket

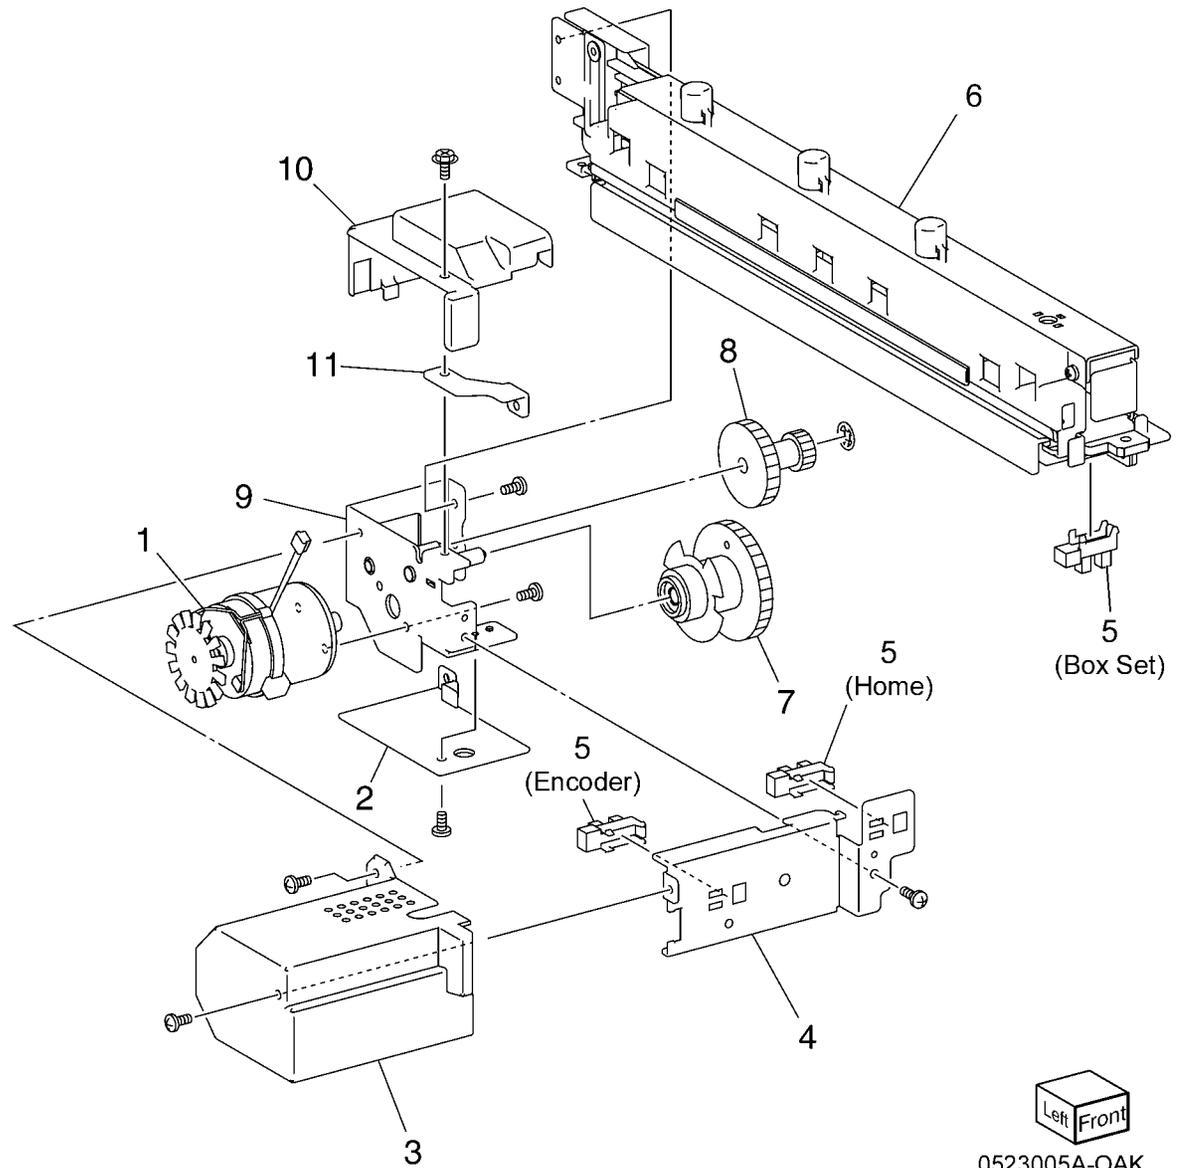
PL 23.5 H - Transport Assembly (5 of 5)

Item	Part	Description
1	-	Punch Motor (P/O PL 23.2 Item 10)
2	-	Punch Lower Cover (P/O PL 23.2 Item 10)
3	-	Punch Motor Cover (P/O PL 23.2 Item 10)
4	-	Sensor Bracket (P/O PL 23.2 Item 10)
5	930W00111	Punch Encoder Sensor, Punch Home Sensor, Punch Box Set Sensor
6	-	Punch Frame Assembly (P/O PL 23.2 Item 10)
7	-	Encoder/Gear Assembly (P/O PL 23.2 Item 10)
8	-	Gear (P/O PL 23.2 Item 10)
9	-	Motor Bracket (P/O PL 23.2 Item 10)
10	-	Punch Top Cover (P/O PL 23.2 Item 10)
11	-	Bracket (P/O PL 23.2 Item 10)

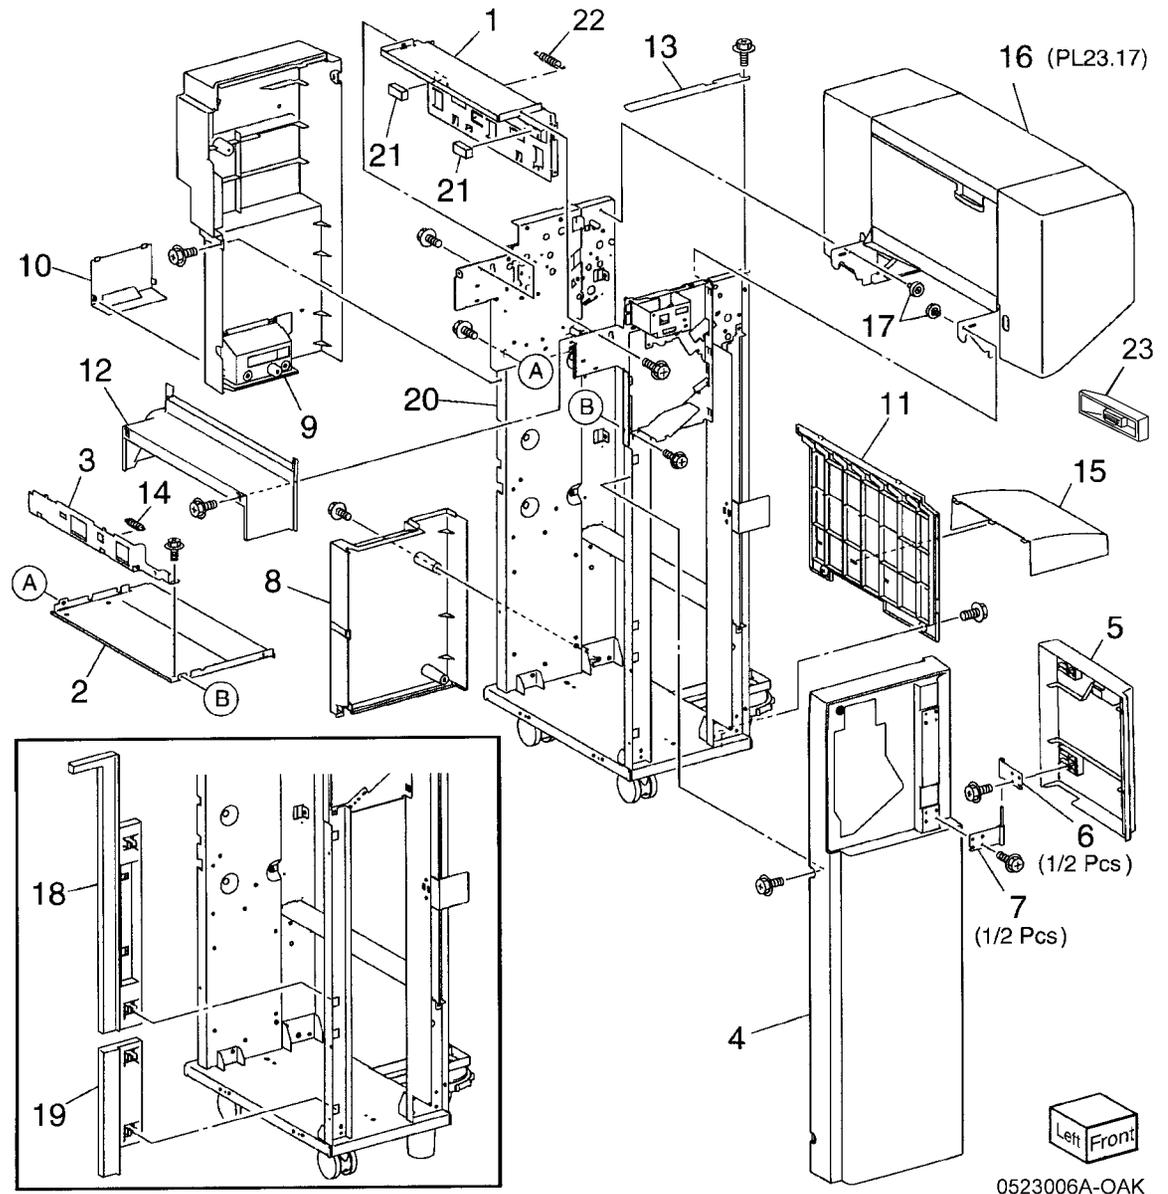
PL 23.6 Finisher Covers

Item	Part	Description
1	-	Plate (Not Spared)
2	-	Lower Plate (Not Spared)
3	-	Docking Lever (Not Spared)
4	-	Front Cover (REP 13.6)
5	-	Front Door (Not Spared)
6	-	Bracket (Not Spared)
7	068K59531	Hinge
8	848E15210	Rear Lower Cover (REP 13.8)
9	848E15221	Rear Upper Cover (REP 13.7)
10	848E15231	Connector Cover
11	848E15241	Stacker Lower Cover (REP 13.11)
12	848E48790	LH Cover
13	-	Cover (Not Spared)
14	-	Spring (Not Spared)
15	848E22450	Foot Cover (REP 13.10)
16	801K30701	Booklet Assembly (REP 13.31)
17	-	Thumb Screw (P/O PL 23.1 Item 11)
18	-	Upper Adjust Cover (P/O PL 23.1 Item 11)
19	-	Lower Adjust Cover (Not Spared)
20	-	Base Frame Assembly (Not Spared)
21	921W41162	Gasket
22	-	Extension Spring (Not Spared)
23	-	Paper Guide

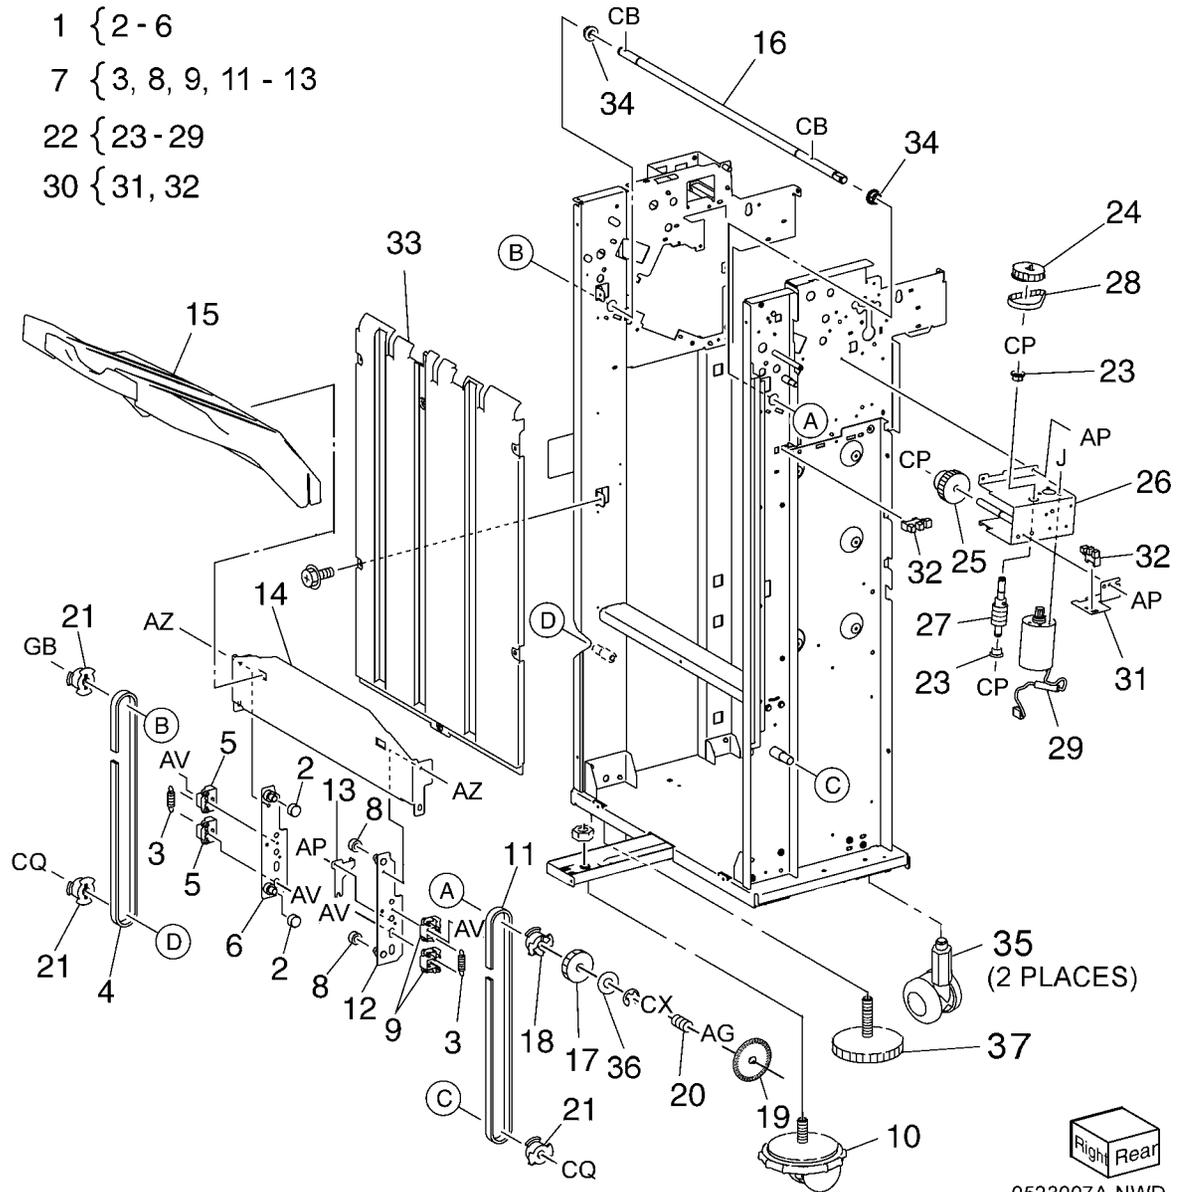
PL 23.7 Finisher Stacker

Item	Part	Description
1	041K95980	Front Carriage Assembly (REP 13.29)
2	-	Bearing (P/O PL 23.7 Item 1)
3	809E56850	Spring
4	-	Front Stacker Belt (P/O PL 23.7 Item 1)
5	-	Clamp (P/O PL 23.7 Item 1)
6	-	Front Carriage Assembly (P/O PL 23.7 Item 1)
7	041K95990	Rear Carriage Assembly (REP 13.29)
8	-	Bearing (P/O PL 23.7 Item 7)
9	-	Clamp (P/O PL 23.7 Item 7)
10	017K94890	Knob Caster Assembly
11	-	Rear Stacker Belt (P/O PL 23.7 Item 7)
12	-	Rear Carriage (P/O PL 23.7 Item 7)
13	-	Actuator (P/O PL 23.7 Item 7)
14	-	Carriage Tray (Not Spared)
15	050K61105	Stacker Tray (REP 13.20)
16	-	Shaft (Not Spared)
17	807E08990	Gear
18	020E37710	Pulley
19	146E90650	Encoder
20	809E56860	Spring
21	020E37720	Pulley (18T)
22	068K58304	Stacker Elevator Motor Assembly (REP 13.19)

-	068K58303	Stacker Elevator Motor Assembly (REP 13.19)
23	-	Bearing (P/O PL 23.7 Item 22)
24	020E44181	Pulley (60T)
25	-	Gear (15T/37T) (P/O PL 23.7 Item 22)
26	-	Motor Bracket (P/O PL 23.7 Item 22)
27	-	Worm Shaft (P/O PL 23.7 Item 22)
28	423W27654	Belt
29	-	Stacker Elevator Motor (P/O PL 23.7 Item 22)
30	-	Stacker Encoder Sensor Assembly (Not Spared)
31	-	Bracket (P/O PL 23.7 Item 30)
32	930W00111	Stacker Encoder Sensor, Stacker No Paper Sensor
33	-	Stacker Upper Cover (Not Spared) (REP 13.12)
34	413W79359	Bearing
35	017K94880	Caster Assembly
36	251W31178	Washer
37	017K94900	Adjustable Foot Assembly

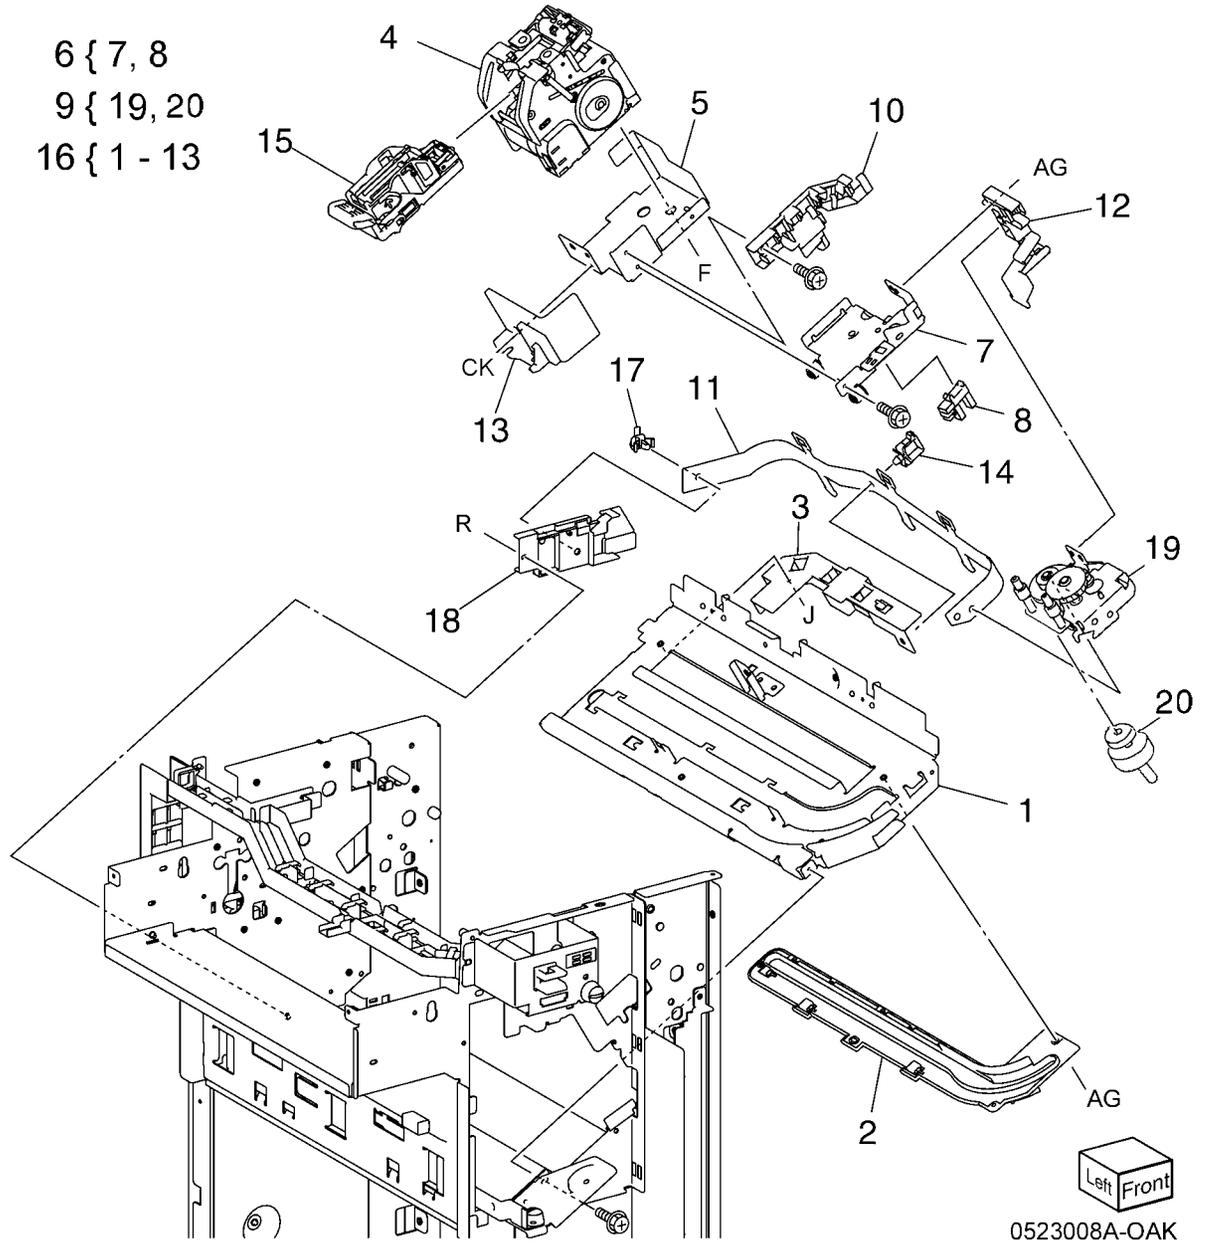
PL 23.8 Finisher Stapler

Item	Part	Description
1	-	Base Frame (P/O PL 23.8 Item 16)
2	-	Rail (P/O PL 23.8 Item 16)
3	-	Harness Guide
4	029K92350	Stapler Assembly (REP 13.16)
5	-	Holder (Not Spared)
6	-	Stapler Move Position Sensor Assembly (Not Spared)
7	-	Bracket (P/O PL 23.8 Item 6)
8	130E94940	Stapler Move Position Sensor
9	-	Stapler Move Motor Assembly (Not Spared)
10	-	Harness Guide (P/O PL 23.8 Item 16)
11	-	Harness Support Guide (P/O PL 23.8 Item 16)
12	-	Harness Guide (P/O PL 23.8 Item 16)
13	-	Stapler Cover (Not Spared)
14	-	Clamp (Not Spared)
15	-	Stapler Cartridge (Not Spared)
16	-	Stapler Unit (Not Spared)
17	-	Cable Band (Not Spared)
18	-	Harness Guide (Not Spared)
19	-	Stapler Motor Assembly (P/O PL 23.8 Item 9) (REP 13.15)
20	127K57622	Motor Assembly

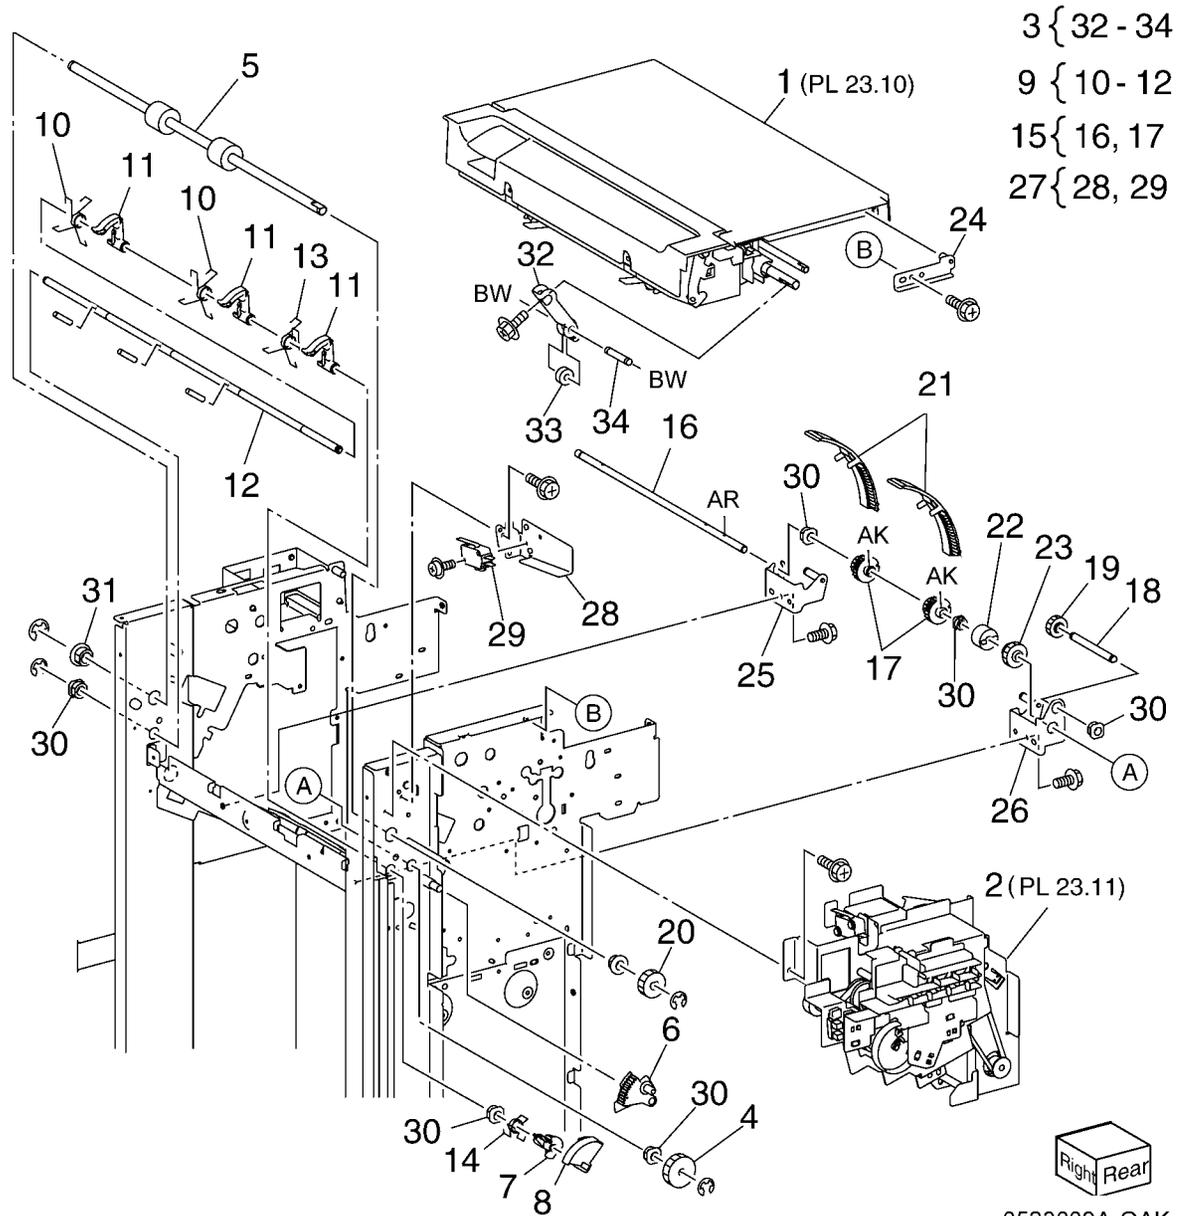
PL 23.9 Finisher Eject (1 of 5)

Item	Part	Description
1	-	Eject Cover Assembly (Not Spared)
2	-	Eject Assembly (Not Spared)
3	031K93790	Clamp Arm Assembly
4	807E21370	Gear (25T)
5	059K55111	Eject Roller
6	807E21380	Gear (72T)
7	807E21391	Gear (18T)
8	120E29772	Actuator

-	120E29771	Actuator
9	006K86731	Set Clamp Shaft Assembly
10	-	Spring (P/O PL 23.9 Item 9)
11	019K09391	Set Clamp Holder
12	-	Shaft (Not Spared)
13	809E79060	Spring
14	809E79080	Spring
15	006K86741	Guide Paper Shaft Assembly
16	-	Guide Paper Shaft (P/O PL 23.9 Item 15)
17	-	Gear (20T) (P/O PL 23.9 Item 15)
18	-	Shaft (Not Spared)
19	807E21420	Gear (19T)
20	807E21400	Gear (31T)
21	038E36490	Guide Paper (Left/Right)
22	005E25820	Clutch
23	807E21970	Gear (23T)
24	-	Stopper (Not Spared)
25	-	Bracket (Front) (Not Spared)
26	-	Bracket (Rear) (Not Spared)
27	-	Option Switch Assembly (Not Spared)
28	-	Bracket (Not Spared)
29	-	Option Switch (Not Spared)
30	413W77559	Sleeve Bearing
31	-	Bearing (Not Spared)
32	-	Clamp Arm (P/O PL 23.9 Item 3)
33	-	Roll (P/O PL 23.9 Item 3)
34	-	Shaft (P/O PL 23.9 Item 3)
