WorkCentre 5335 Family Service Documentation

705P01303

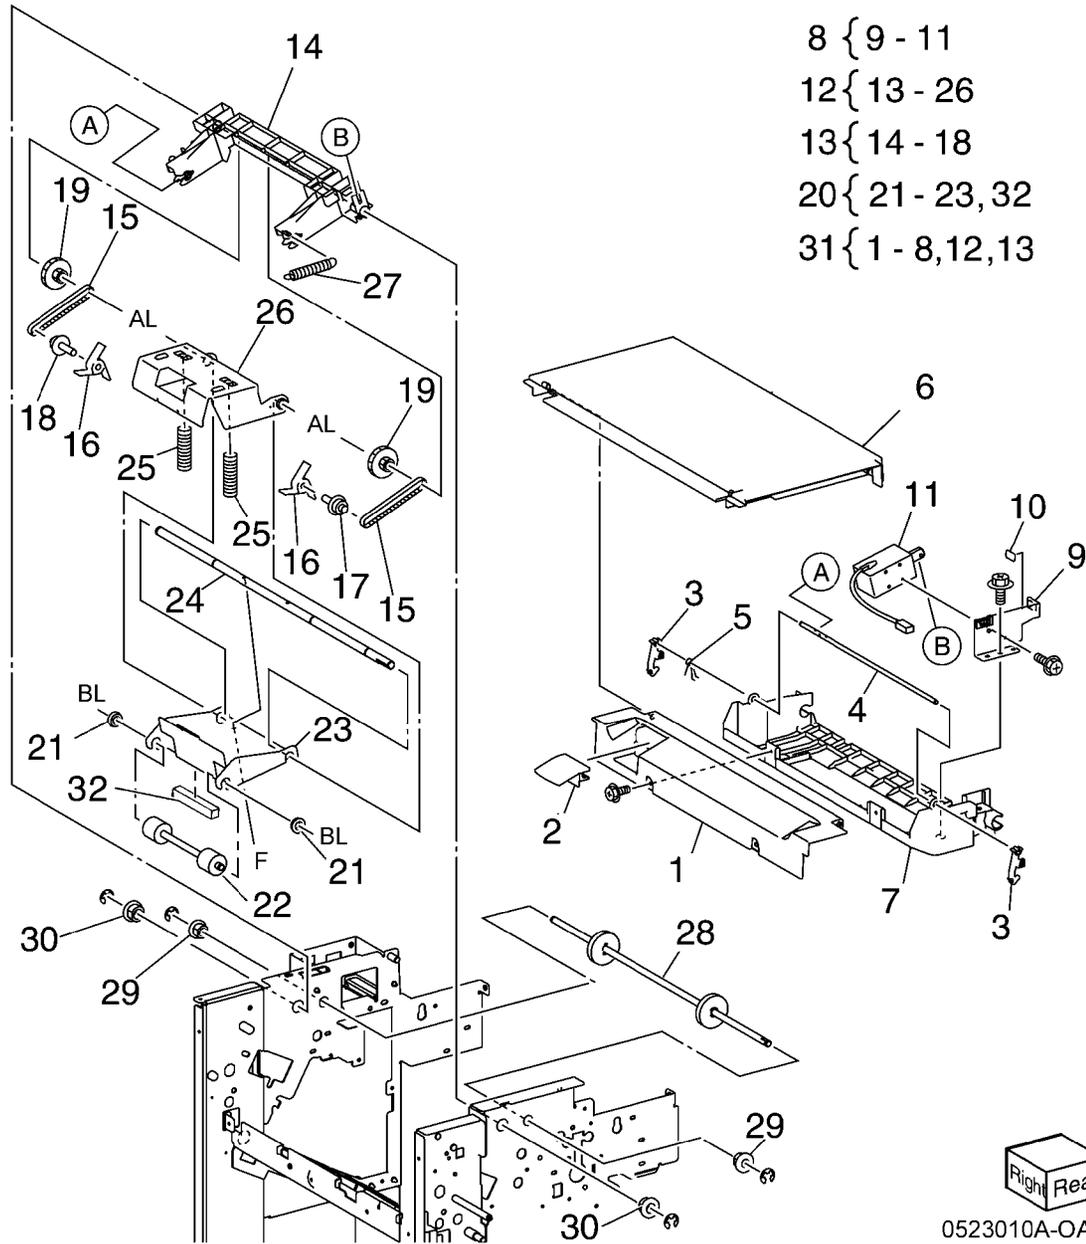
Item	Part	Description
1	848E15291	Top Right Hand Cover
2	011E20781	Top Cover Lever
3	003E76111	Top Cover Latch
4	-	Shaft (Not Spared)
5	809E79031	Spring
6	-	Eject Cover (REP 13.9)
7	054K35301	Eject Chute
8	121K41632	Sub Paddle Solenoid Assembly (REP 13.14)
9	-	Bracket (P/O PL 23.10 Item 8)
10	-	Damper (P/O PL 23.10 Item 8)
11	-	Sub Paddle Solenoid (P/O PL 23.10 Item 8)
12	-	Eject Roller Assembly (Not Spared)
13	031K93770	Paddle Arm Assembly
14	-	Sub Paddle Arm (Not Spared)
15	423W08655	Belt
16	-	Sub Paddle (P/O PL 23.10 Item 13)
17	-	Pulley (P/O PL 23.10 Item 13)
18	-	Pulley (P/O PL 23.10 Item 13)
19	-	Gear/Pulley (31T/20T) (Not Spared)
20	-	Eject Pinch Roller Assembly (Not Spared)
21	-	Bearing (P/O PL 23.10 Item 20)
22	059K55102	Eject Pinch Roller
23	-	Bracket (P/O PL 23.10 Item 20)
24	-	Shaft (P/O PL 23.10 Item 12)
25	-	Spring (Not Spared)
26	-	Bracket (P/O PL 23.10 Item 12)
27	809E79050	Spring
28	006K86690	Eject Drive Shaft

29	-	Bearing (Not Spared)
30	-	Bearing (Not Spared)
31	-	Eject Chute Assembly (Not Spared)
32	-	Eject Eliminator (P/O PL 23.10 Item 20)

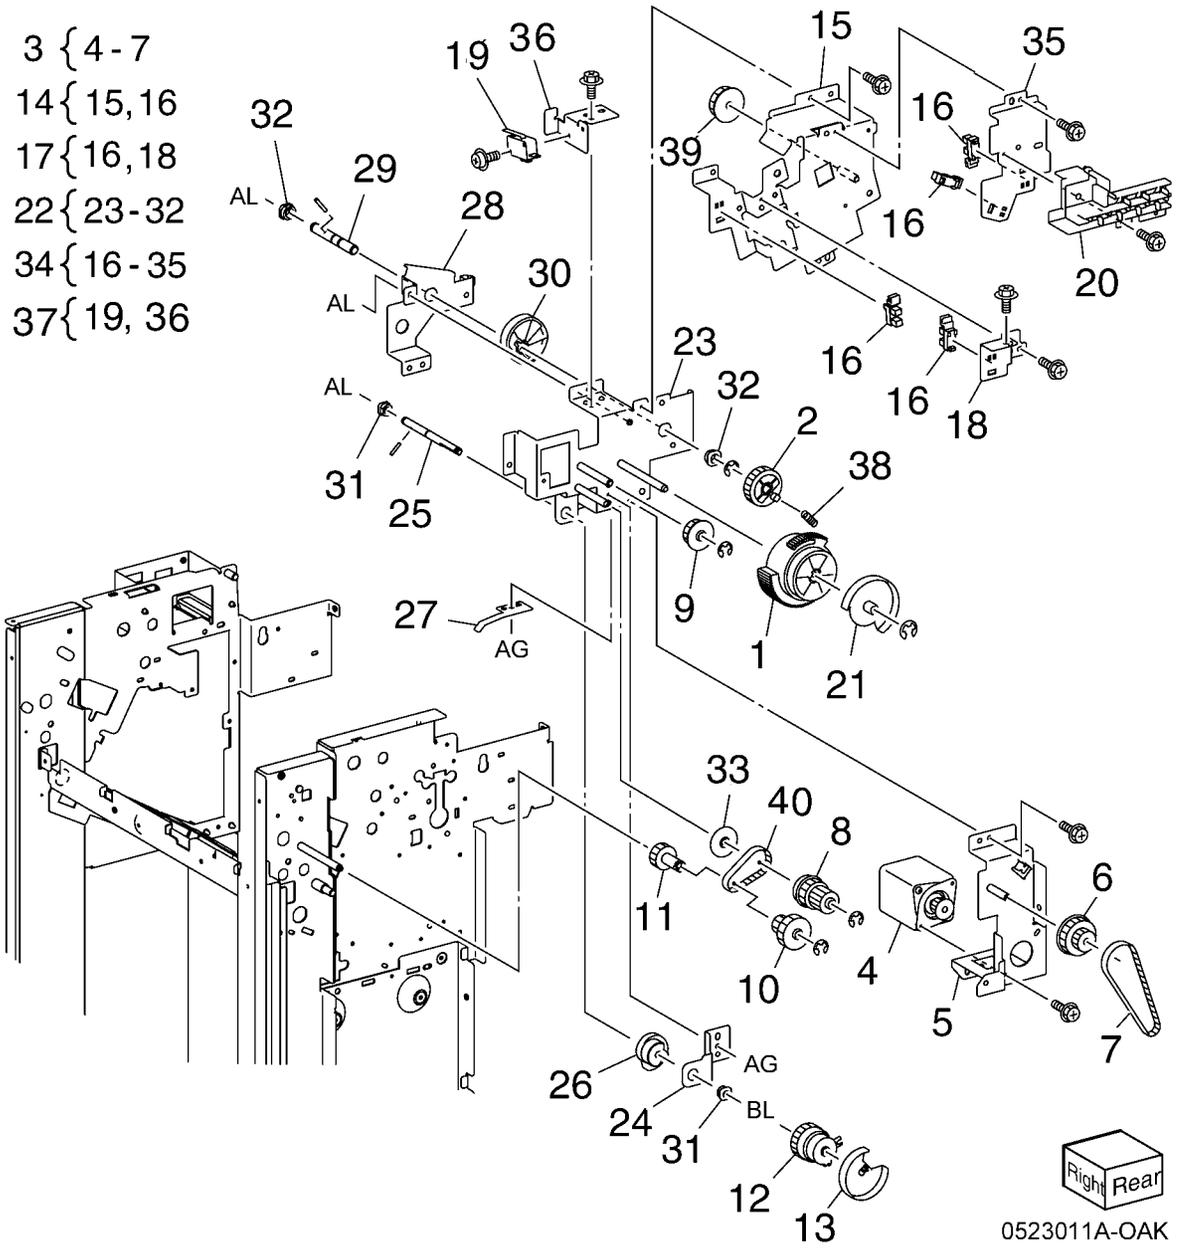
Item	Part	Description
1	807E20931	Gear (82T/77T/51T)
2	807E20940	Gear (38T)
3	-	Eject Motor Assembly (Not Spared)
4	127K53140	Eject Motor (REP 13.25)
5	-	Bracket (P/O PL 23.11 Item 3)
6	807E22030	Gear/Pulley (20T/49T)
7	423W31054	Belt
8	807E21330	Gear (28T/22T/38T)
9	807E21340	Gear (25T)
10	807E21350	Gear/Pulley (32T/25T)
11	807E21360	Gear (23T)
12	121K34631	Set Clamp Clutch (34T)
13	120E29591	Set Clamp Cam Actuator
14	130K72170	Stacker Height Sensor 1 Assembly
15	-	Bracket (P/O PL 23.11 Item 14)
16	930W00111	Stacker Height Sensor 1, Stacker Height Sensor 2, Eject Clamp Home Sensor, Set Clamp Home Sensor (REP 13.13)
17	130K72180	Stacker Height Sensor 2 Assembly
18	-	Bracket (P/O PL 23.11 Item 17)
19	-	Eject Cover Switch (P/O PL 23.11 Item 37)
20	-	Harness Guide (Not Spared)
21	120E29850	Gear Select Actuator
22	-	Eject Drive Bracket Assembly (Not Spared)
23	-	Bracket (P/O PL 23.11 Item 22)
24	-	Bracket (P/O PL 23.11 Item 22)

25	-	Shaft (P/O PL 23.11 Item 22)
26	008E96770	Clamp Set Cam
27	809E79070	Spring
28	-	Bracket (P/O PL 23.11 Item 22)
29	-	Shaft (P/O PL 23.11 Item 22)
30	008E96691	Eject Clamp Cam
31	413W11660	Sleeve Bearing
32	-	Sleeve Bearing (P/O PL 23.11 Item 22)
33	005E25810	Drive Eject Flange
34	130K72190	Eject Clamp Home Sensor Assembly
35	-	Bracket (P/O PL 23.11 Item 34)
36	-	Bracket (P/O PL 23.11 Item 37)
37	-	Eject Cover Switch Assembly (Not Spared)
38	809E79820	Spring
39	807E22040	Gear (30T)
40	423W25954	Belt

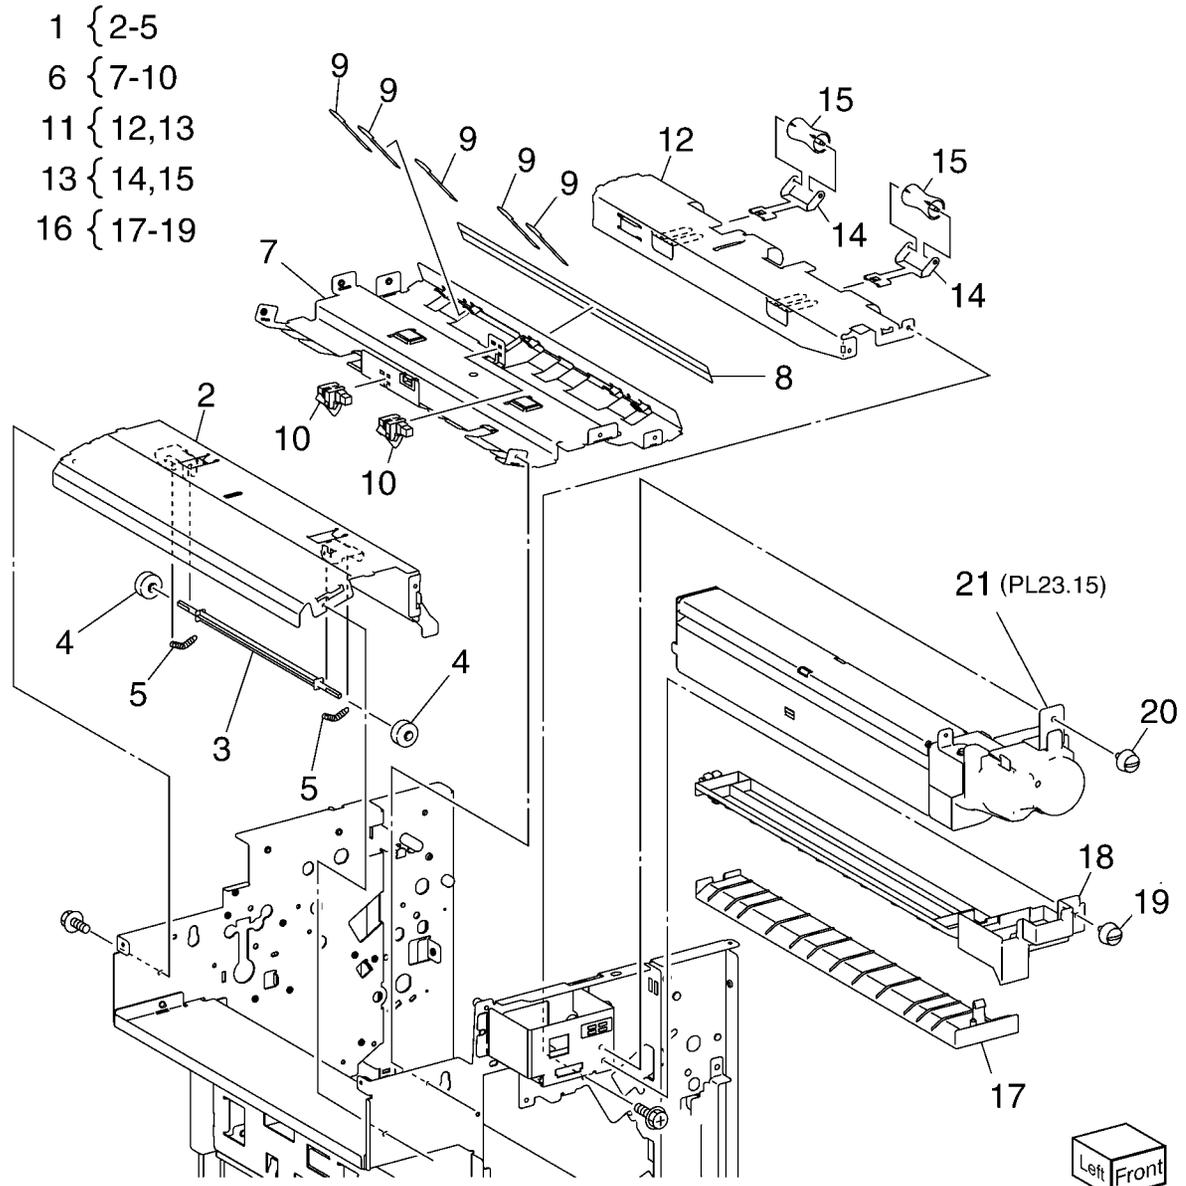
PL 23.14 Finisher Exit/Folder Assembly

Item	Part	Description
1	-	Lower Chute Assembly (Not Spared)
2	-	Lower Chute (P/O PL 23.14 Item 1)
3	806E22121	Shaft
4	059E03710	Pinch Roll
5	809E78960	Spring
6	054K35540	Exit Upper Chute Assembly
7	-	Exit Upper Chute (P/O PL 23.14 Item 6)
8	105E18000	Static Eliminator
9	038E36420	Paper Guide
10	130K88311	Compiler Exit Sensor, Finisher Entrance Sensor
11	054K35559	Exit Lower Chute Assembly
-	054K35558	Exit Lower Chute Assembly (A)
12	-	Exit Lower Chute (P/O PL 23.14 Item 11)
13	-	Pinch Roll Assembly (P/O PL 23.14 Item 11)
14	-	Spring (P/O PL 23.14 Item 13)
15	059K56321	Pinch Roll
16	-	Chute Assembly (Not Spared)
17	-	Lower Chute (P/O PL 23.14 Item 16)
18	-	Upper Chute (P/O PL 23.14 Item 16)
19	-	Thumb Screw (P/O PL 23.14 Item 16)
20	-	Chute Assembly (Not Spared)
21	695K18691	Crease Assembly (Option) (REP 13.18)

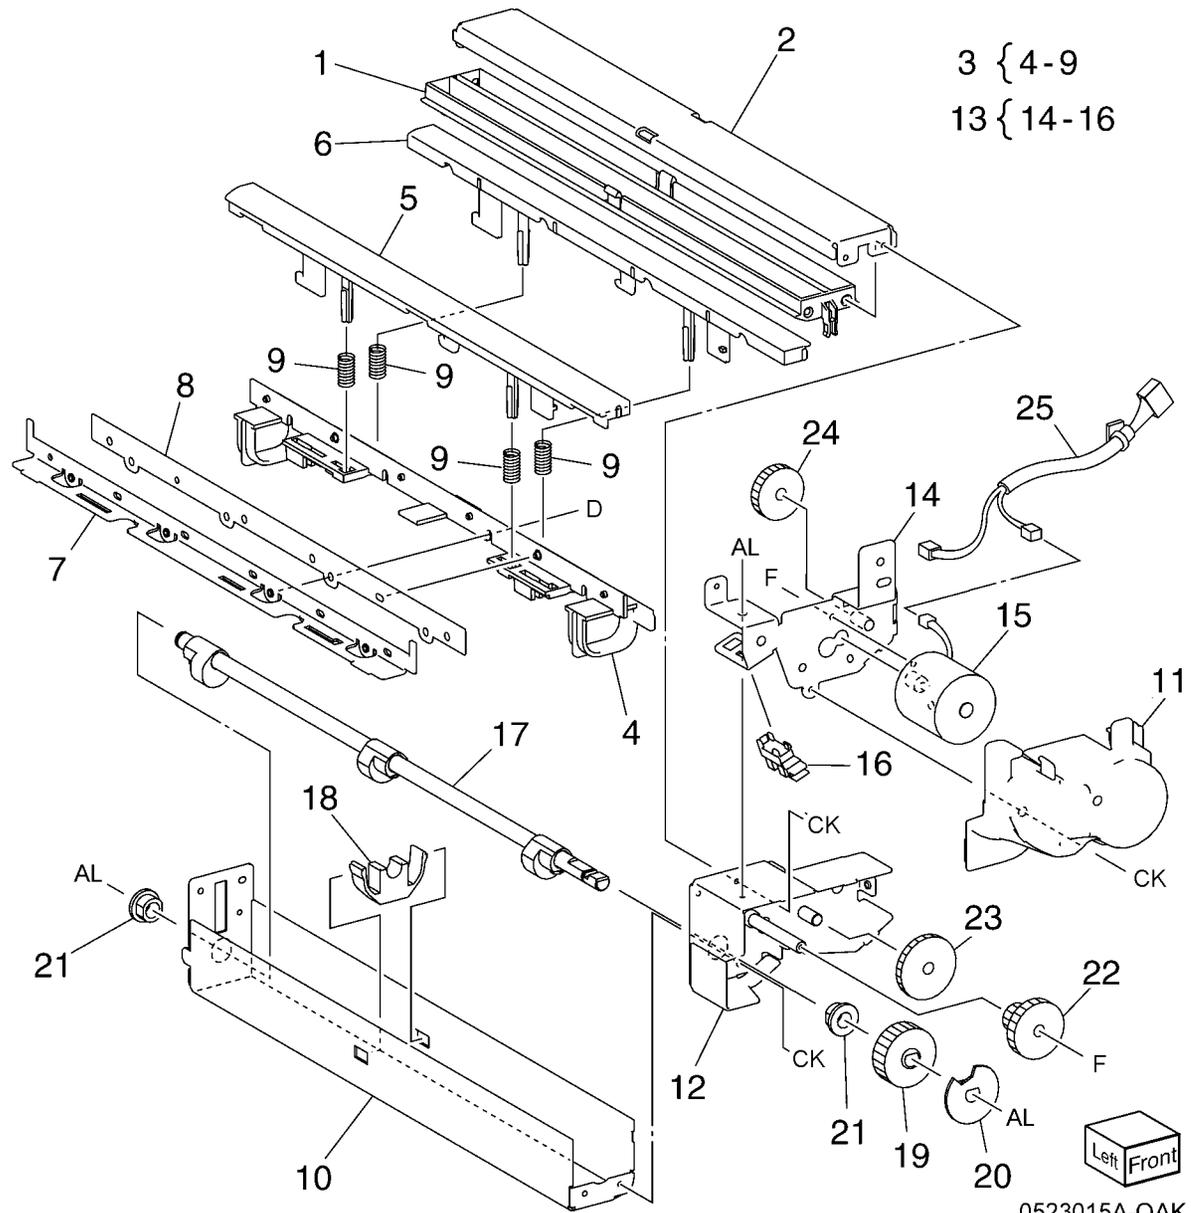
PL 23.15 Folder Assembly

Item	Part	Description
1	-	Upper Chute (P/O PL 23.14 Item 21)
2	-	Upper Plate (P/O PL 23.14 Item 21)
3	-	Knife Assembly (P/O PL 23.14 Item 21)
4	-	Blade Holder (P/O PL 23.15 Item 3)
5	-	Lower Holder 1 (P/O PL 23.15 Item 3)
6	-	Lower Holder 2 (P/O PL 23.15 Item 3)
7	-	Bracket (P/O PL 23.15 Item 3)
8	-	Blade (P/O PL 23.15 Item 3)
9	-	Spring (P/O PL 23.14 Item 2)
10	-	Frame (P/O PL 23.14 Item 21)
11	-	Front Cover (P/O PL 23.14 Item 21)
12	-	Bracket (P/O PL 23.14 Item 21)
13	-	Folder Knife Motor Assembly (P/O PL 23.14 Item 21)
14	-	Motor Bracket (P/O PL 23.15 Item 13)
15	-	Folder Knife Motor (P/O PL 23.15 Item 13)
16	-	Folder Home Sensor (P/O PL 23.15 Item 13)
17	-	Cam Shaft Assembly (P/O PL 23.14 Item 21)
18	-	Guide (P/O PL 23.14 Item 21)
19	-	Gear (28T/8T) (P/O PL 23.14 Item 21)
20	-	Encoder (P/O PL 23.14 Item 21)
21	-	Bearing (P/O PL 23.14 Item 21)
22	-	Gear (12T/27T) (P/O PL 23.14 Item 21)
23	-	Gear (12T/30T) (P/O PL 23.14 Item 21)

24	-	Gear (12T/51T) (P/O PL 23.14 Item 21)
25	-	Wire Harness (P/O PL 23.14 Item 21)

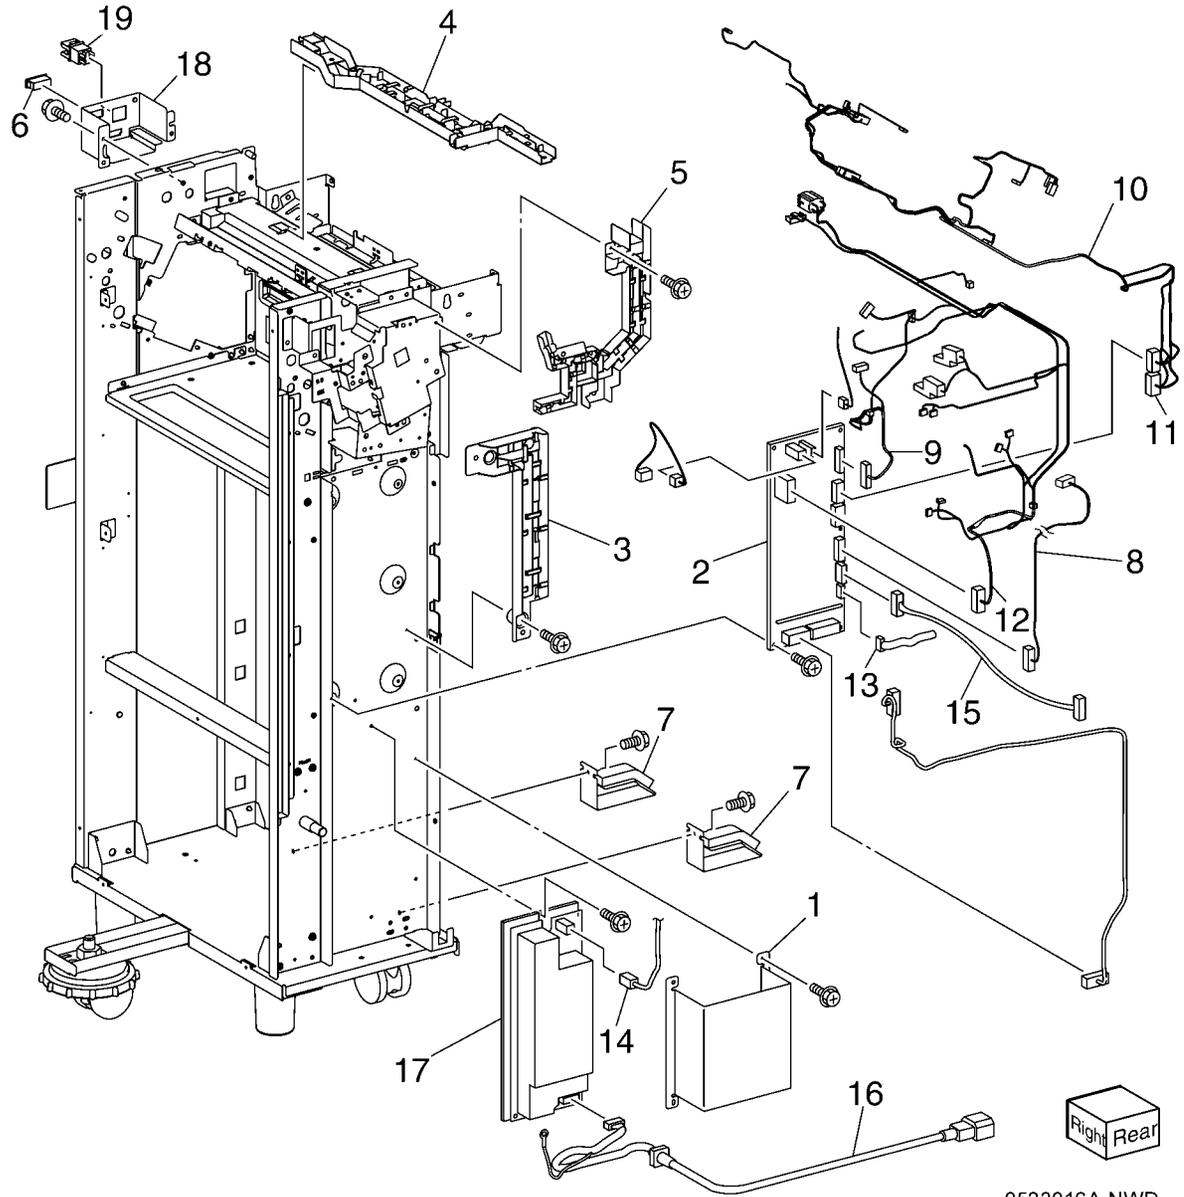
PL 23.16 Finisher Electrical

Item	Part	Description
1	-	LVPS Cover (Not Spared)
2	960K51447	Finisher PWB (REP 13.23)
-	960K50992	Finisher PWB
3	-	Harness Guide (Not Spared)
4	-	Harness Guide (Not Spared)
5	-	Harness Guide (Not Spared)
6	-	Magnet (Not Spared)
7	815K04920	Gasket Plate Assembly
8	962K60592	Wire Harness
9	-	Wire Harness (Not Spared)
10	-	Wire Harness (Not Spared)
11	-	Wire Harness (Not Spared)
12	-	Wire Harness (Not Spared)
13	962K60481	Wire Harness
14	-	Wire Harness (Not Spared)
15	-	Wire Harness (Not Spared)
16	962K74540	Power Cable
17	105E17550	Finisher LVPS (REP 13.24)
18	-	Bracket (Not Spared)
19	110E97990	Finisher Front Door Interlock Switch

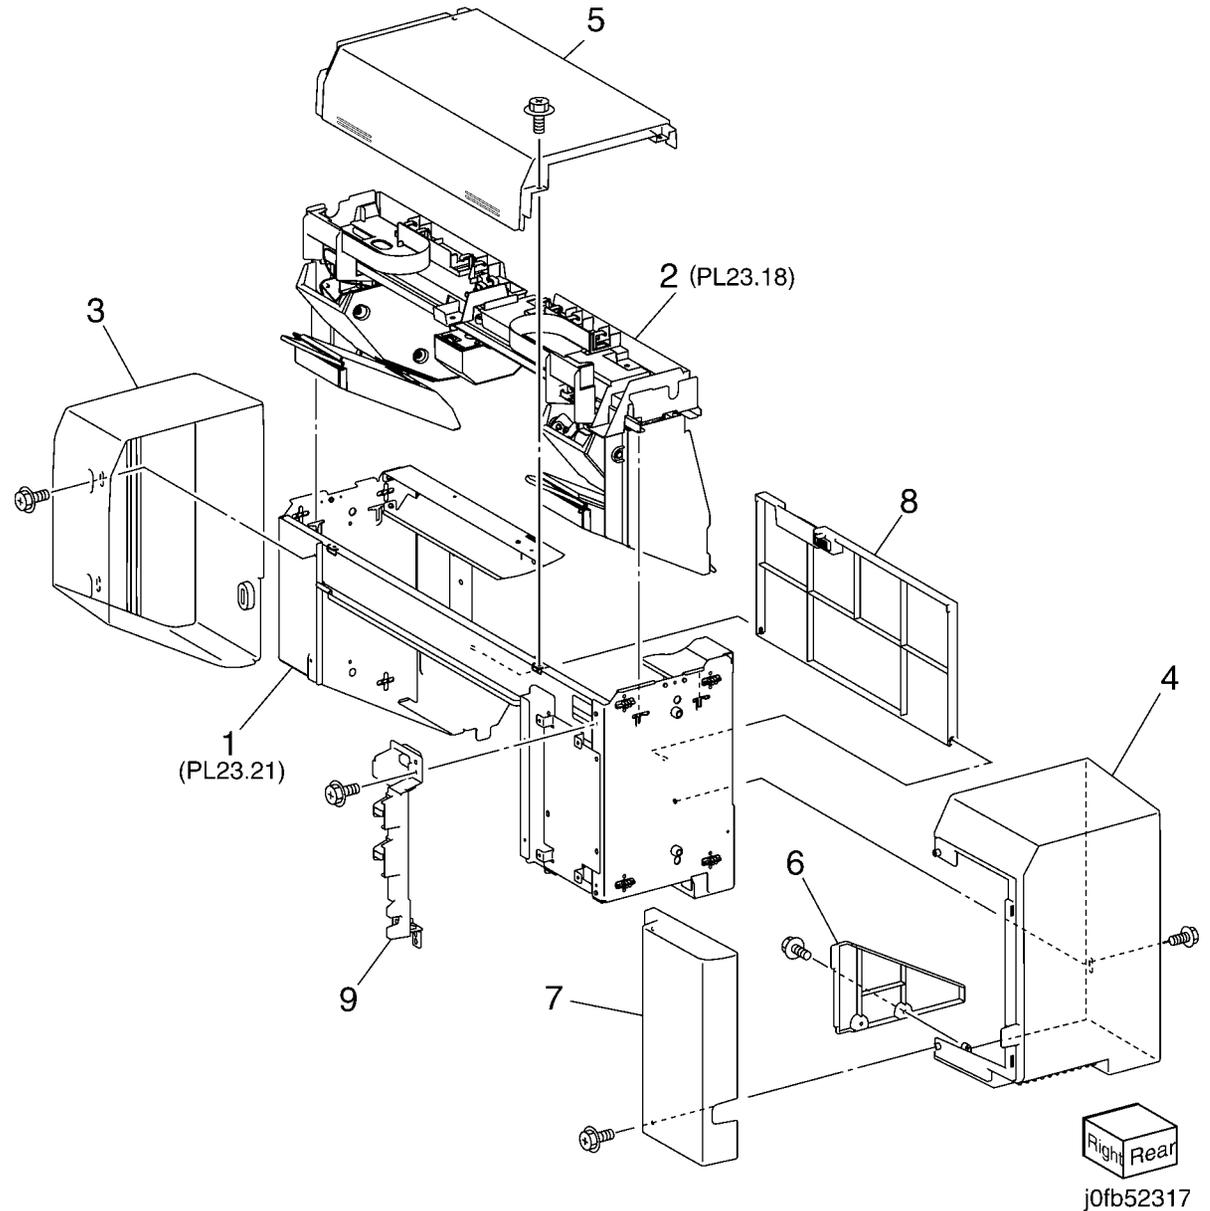
PL 23.17 Booklet Cover

Item	Part	Description
1	-	Frame Assembly (Not Spared)
2	-	Booklet Stapler Assembly (Not Spared)
3	848E15333	Rear Cover (REP 13.33)
4	-	Front Cover (Not Spared) (REP 13.32)
5	-	Top Cover (REP 13.34)
6	848E15350	Side Cover
7	848E15361	PWB Cover (REP 13.35)
8	-	Left Cover (Not Spared) (REP 13.36)
9	-	Harness Guide (Not Spared)

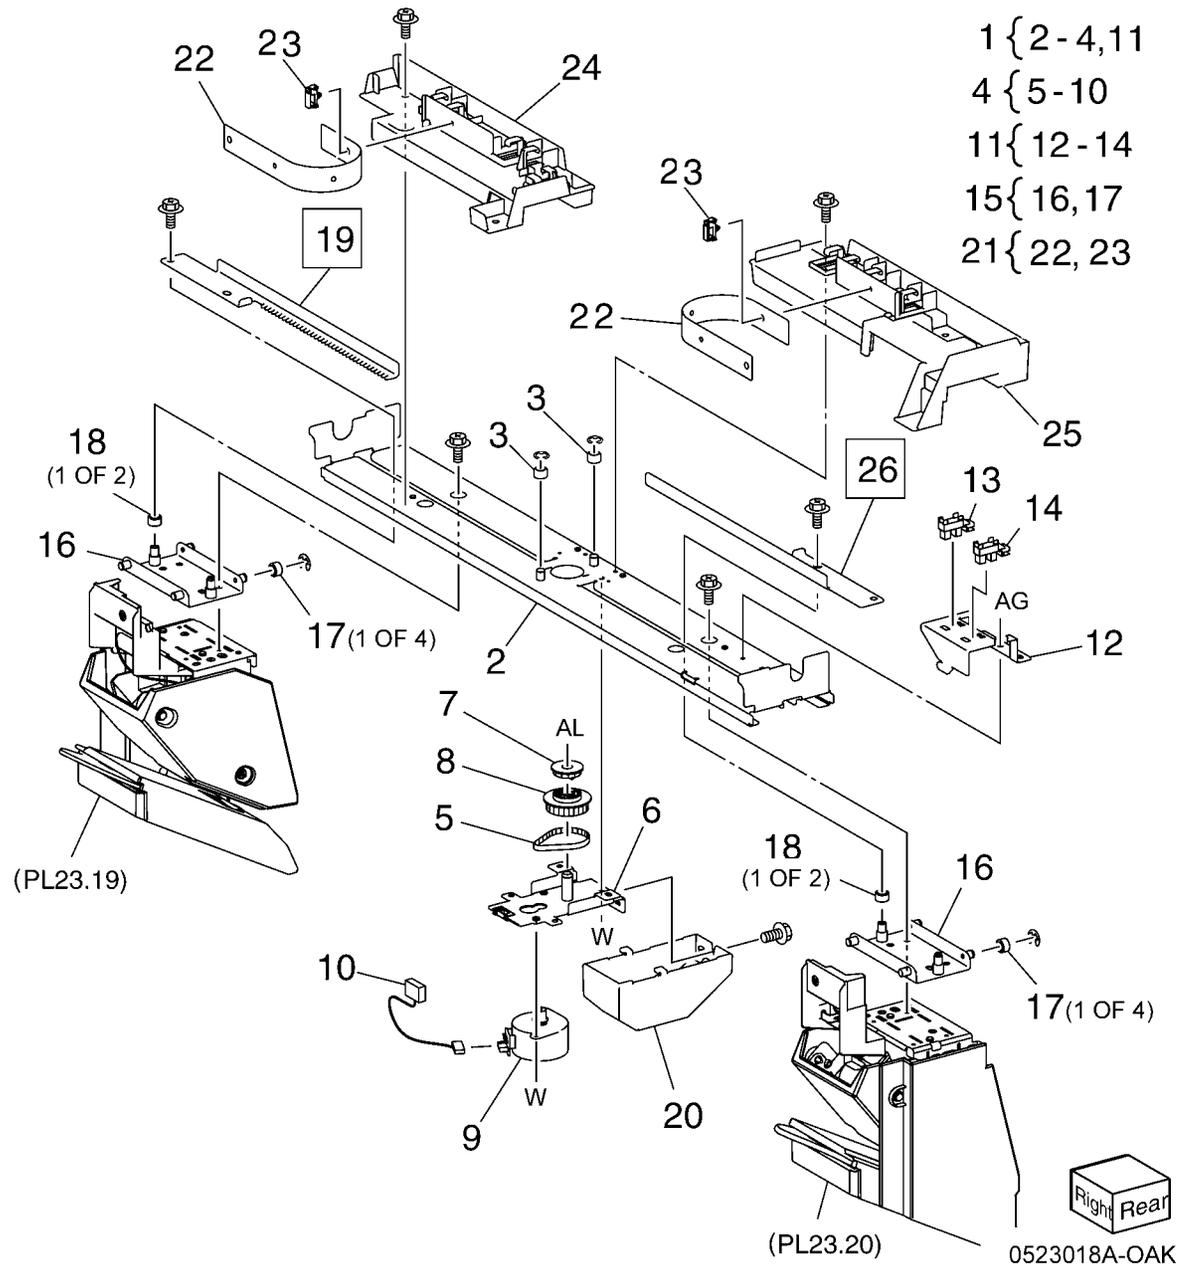
PL 23.18 Booklet Stapler Assembly

Item	Part	Description
1	-	Front Carriage Rail (Not Spared)
2	-	Frame (P/O PL 23.18 Item 1)
3	-	Core (P/O PL 23.18 Item 1)
4	127K57051	Booklet Stapler Move Motor Assembly (REP 13.38)
5	-	Belt (P/O PL 23.18 Item 4)
6	-	Bracket (P/O PL 23.18 Item 4)
7	-	Gear (12T) (P/O PL 23.18 Item 4)
8	-	Pulley (50T) (P/O PL 23.18 Item 4)
9	127K57622	Booklet Stapler Move Motor
10	-	Wire Harness (P/O PL 23.18 Item 4)
11	-	Sensor Bracket Assembly (P/O PL 23.18 Item 1)
12	-	Sensor Bracket (P/O PL 23.18 Item 11)
13	930W00111	Booklet Stapler Move Home Sensor, Booklet Stapler Move Position Sensor
14	-	Rear Rack Gear (Not Spared)
15	-	Carriage Assembly (Not Spared)
16	-	Carriage (P/O PL 23.18 Item 15)
17	-	Core (P/O PL 23.18 Item 15)
18	-	Core (Not Spared)
19	-	Front Rack Gear (Not Spared)
20	848E15400	Motor Cover
21	032K05222	Harness Guide Assembly
22	-	Harness Strap (P/O PL 23.18 Item 21)
23	920W01210	Locking Clamp
24	-	Harness Guide (Front) (Not Spared)

25	-	Harness Guide (Rear) (Not Spared)
26	-	Rear Rack Guide (Not Spared)

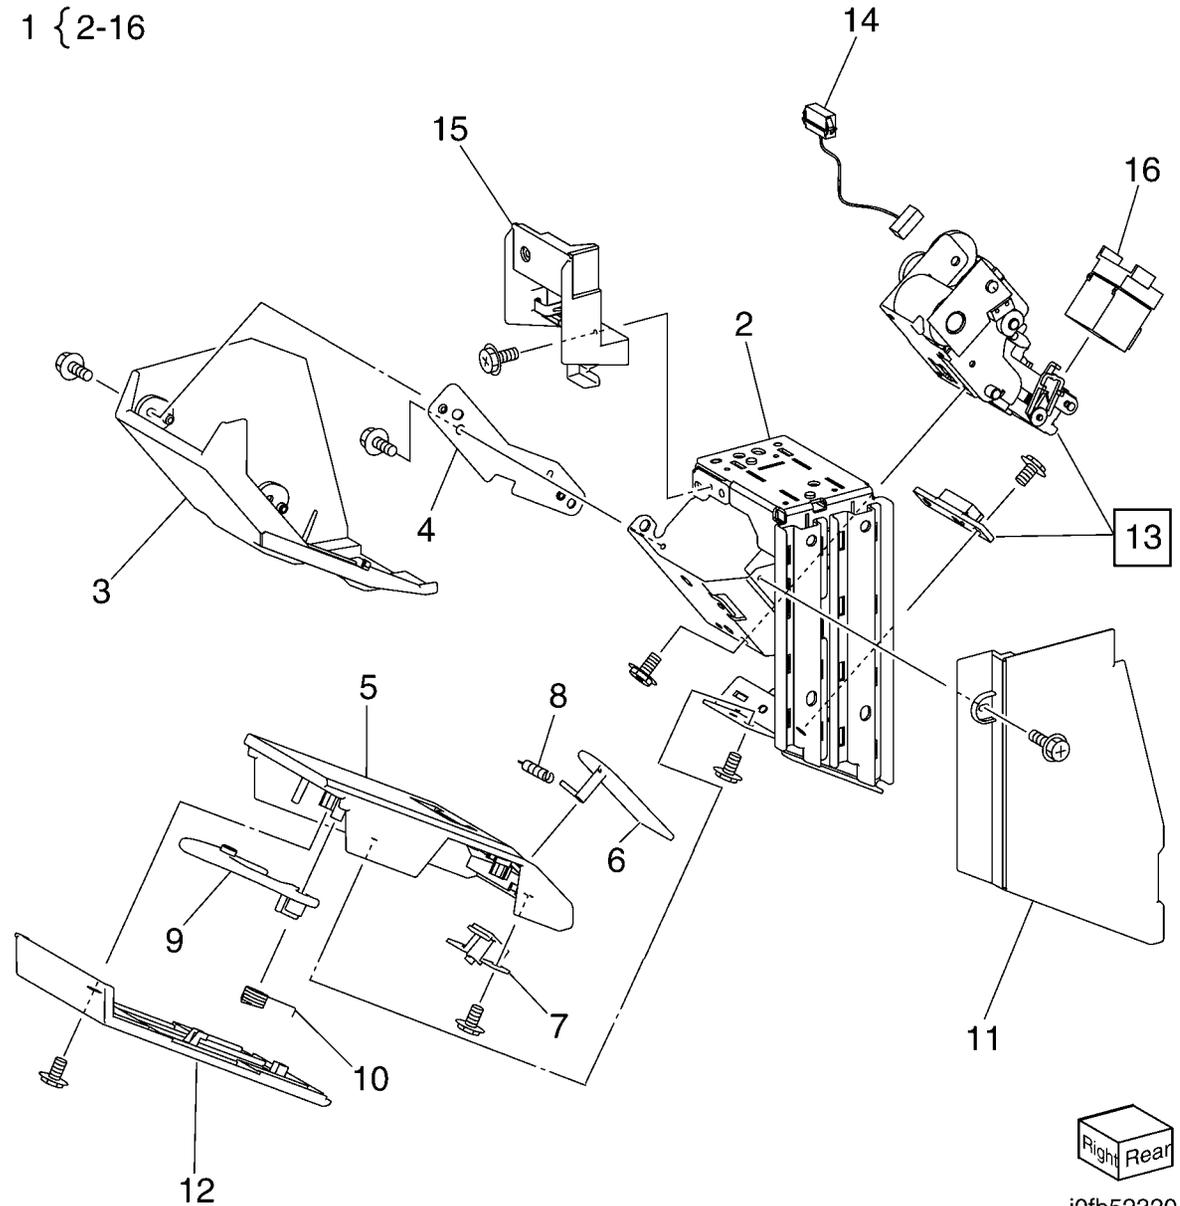
PL 23.20 Booklet Rear Stapler Assembly

Item	Part	Description
1	029K92500	Booklet Rear Stapler Assembly
2	-	Bracket (P/O PL 23.20 Item 1)
3	-	Rear Cover (P/O PL 23.20 Item 1)
4	-	Bracket (P/O PL 23.20 Item 1)
5	054K35282	Chute
6	-	Sub Chute (P/O PL 23.20 Item 1)
7	-	Support (P/O PL 23.20 Item 1)
8	-	Spring (P/O PL 23.20 Item 1)
9	-	Sub Chute (P/O PL 23.20 Item 1)
10	-	Spring (P/O PL 23.20 Item 1)
11	-	Front Cover (P/O PL 23.20 Item 1)
12	848E15421	Lower Cover
13	-	Booklet Stapler Assembly (P/O PL 23.20 Item 1) (REP 13.37)
14	-	Wire Harness (P/O PL 23.20 Item 1)
15	-	Guide (P/O PL 23.20 Item 1)
16	-	Booklet Staple Cassette Assembly (P/O PL 23.20 Item 1)

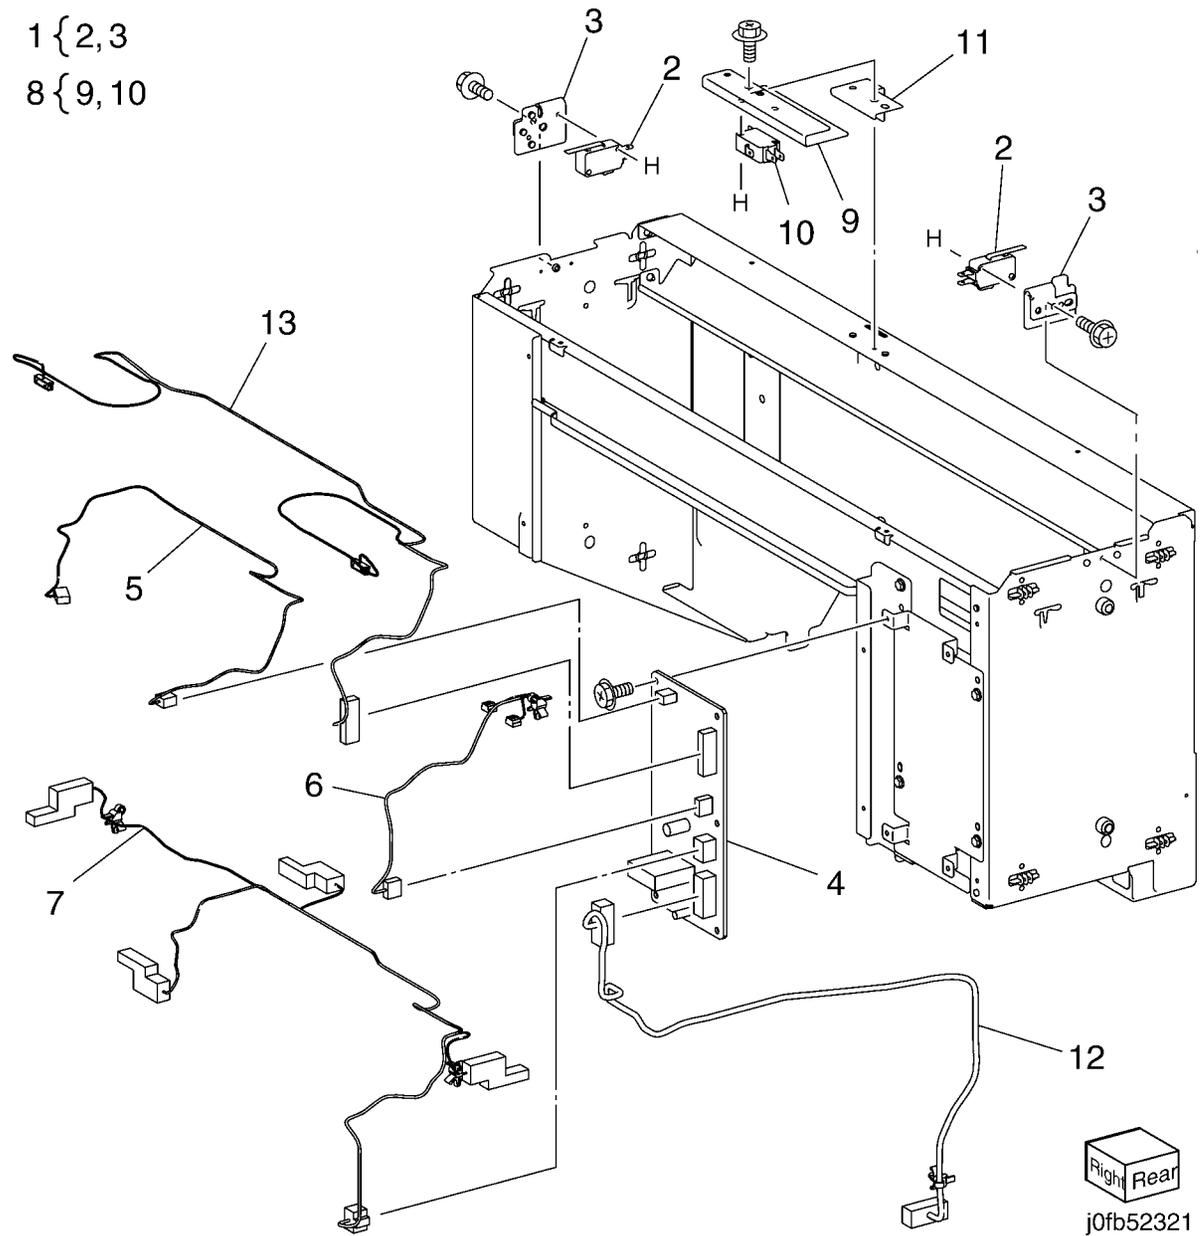
PL 23.21 Booklet Electrical

Item	Part	Description
1	068K58350	Booklet Stapler Safety Switch Assembly
2	110E12970	Booklet Stapler Safety Switch
3	-	Bracket (P/O PL 23.21 Item 1)
4	960K32543	Booklet PWB (REP 13.30)
5	-	Wire Harness (Not Spared)
6	-	Wire Harness (Not Spared)
7	-	Wire Harness (Not Spared)
8	-	Booklet Stapler Cover Switch Assembly (Not Spared)
9	-	Bracket (P/O PL 23.21 Item 8)
10	-	Booklet Stapler Cover Switch (P/O PL 23.21 Item 8)
11	-	Plate (Not Spared)
12	962K60533	Wire Harness
13	962K60540	Wire Harness

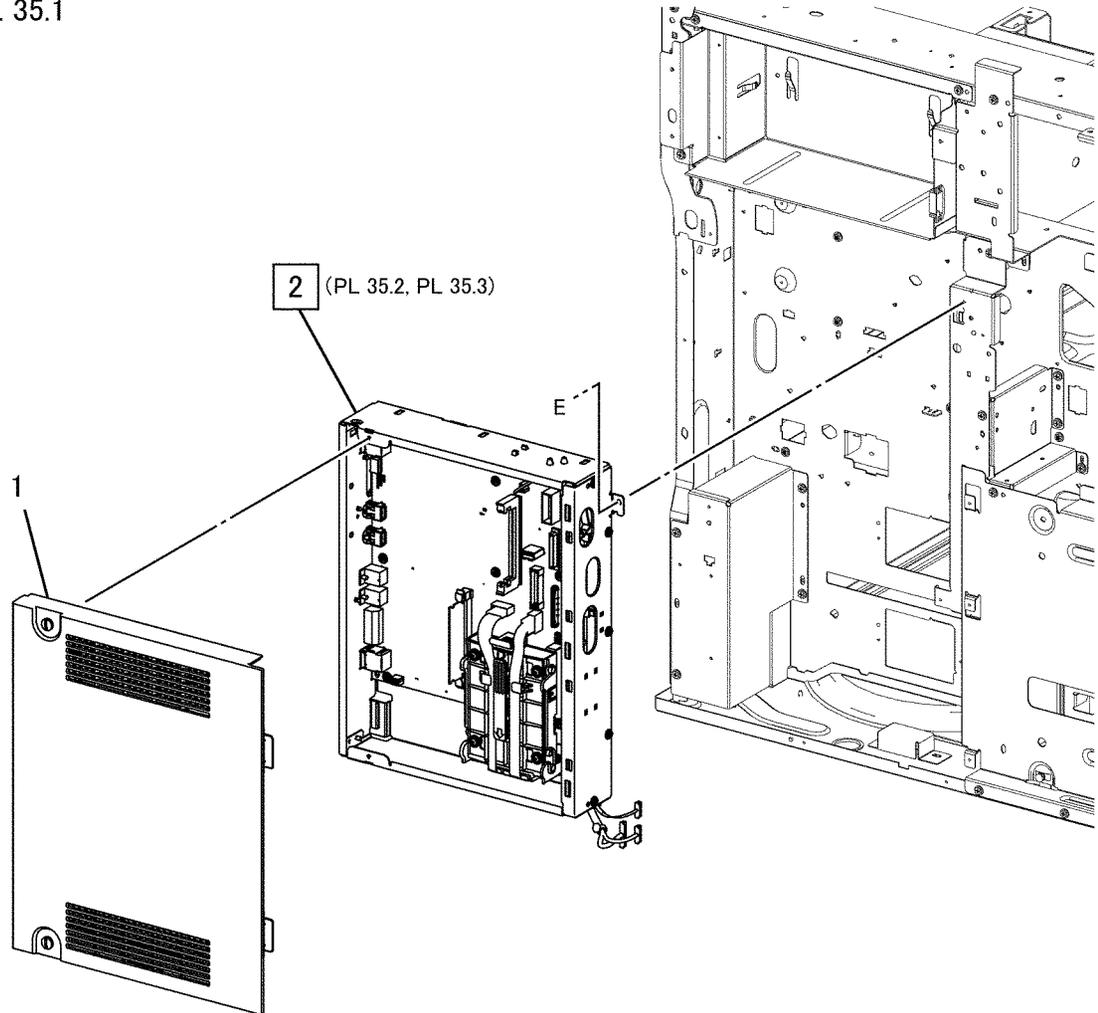
PL 35.1 ESS (1/3)

Item	Part	Description
1	-	ESS Cover (Not Spared)
2	-	ESS Chassis Assembly (REF: PL 35.2, PL 35.3) (REP 3.2)

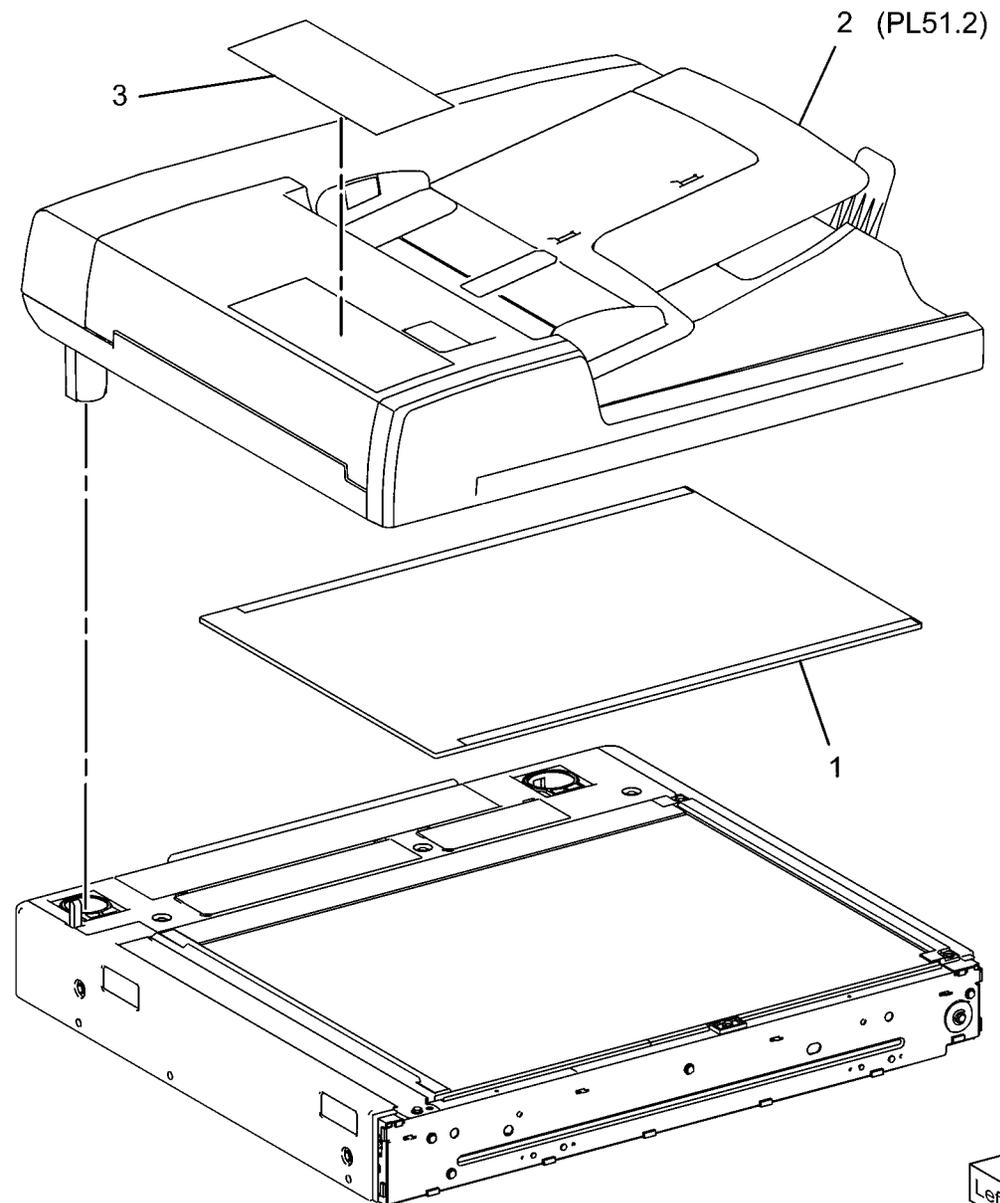
PL51.1

Item	Part	Description
1	004K02962	DADF Platen Cushion (REP 5.2)
2	059K71382	DADF Assembly (REP 5.1)
3	-	Label

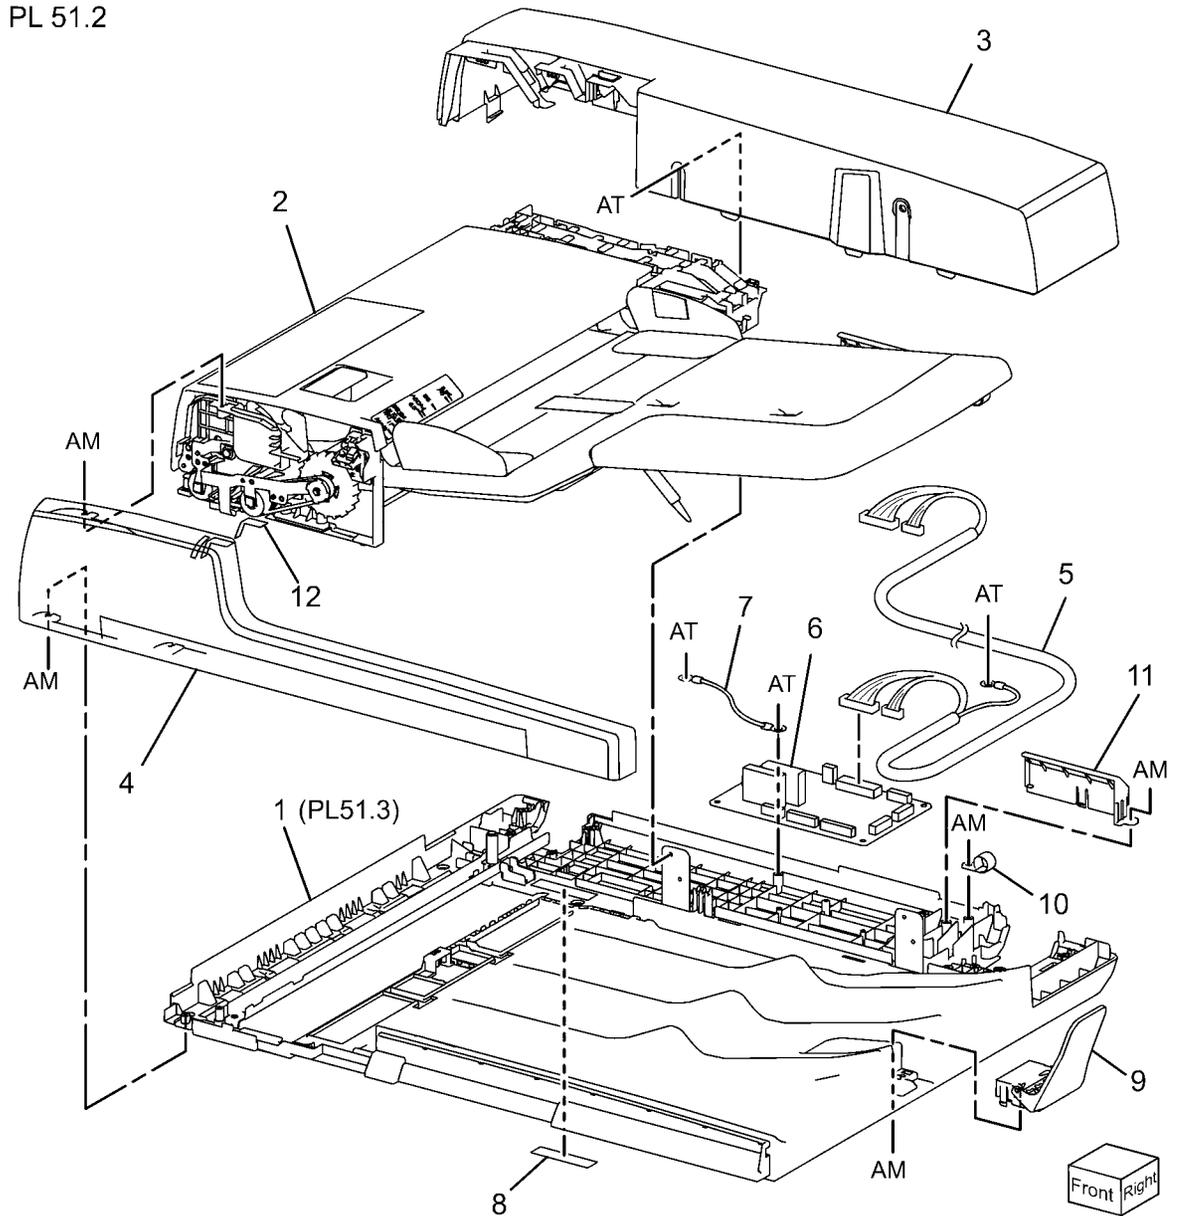
PL 51.2 Covers, PWB

Item	Part	Description
1	-	Base Frame (P/O PL 51.1 Item 2)
2	-	Feeder Assembly (P/O PL 51.1 Item 2) (REP 5.5)
3	-	Rear Cover (P/O PL 51.1 Item 2) (REP 5.4)
4	-	Front Cover (P/O PL 51.1 Item 2) (REP 5.3)
5	962K71100	Transport Harness
6	960K47306	DADF PWB (REP 5.6)
7	-	Wire Harness (P/O PL 51.1 Item 2)
8	-	Data Plate (P/O PL 51.1 Item 2)
9	003K87990	Stopper
10	-	P Clamp (P/O PL 51.1 Item 2)
11	-	Bracket (P/O PL 51.1 Item 2)
12	-	Knob Label (Not Spared)

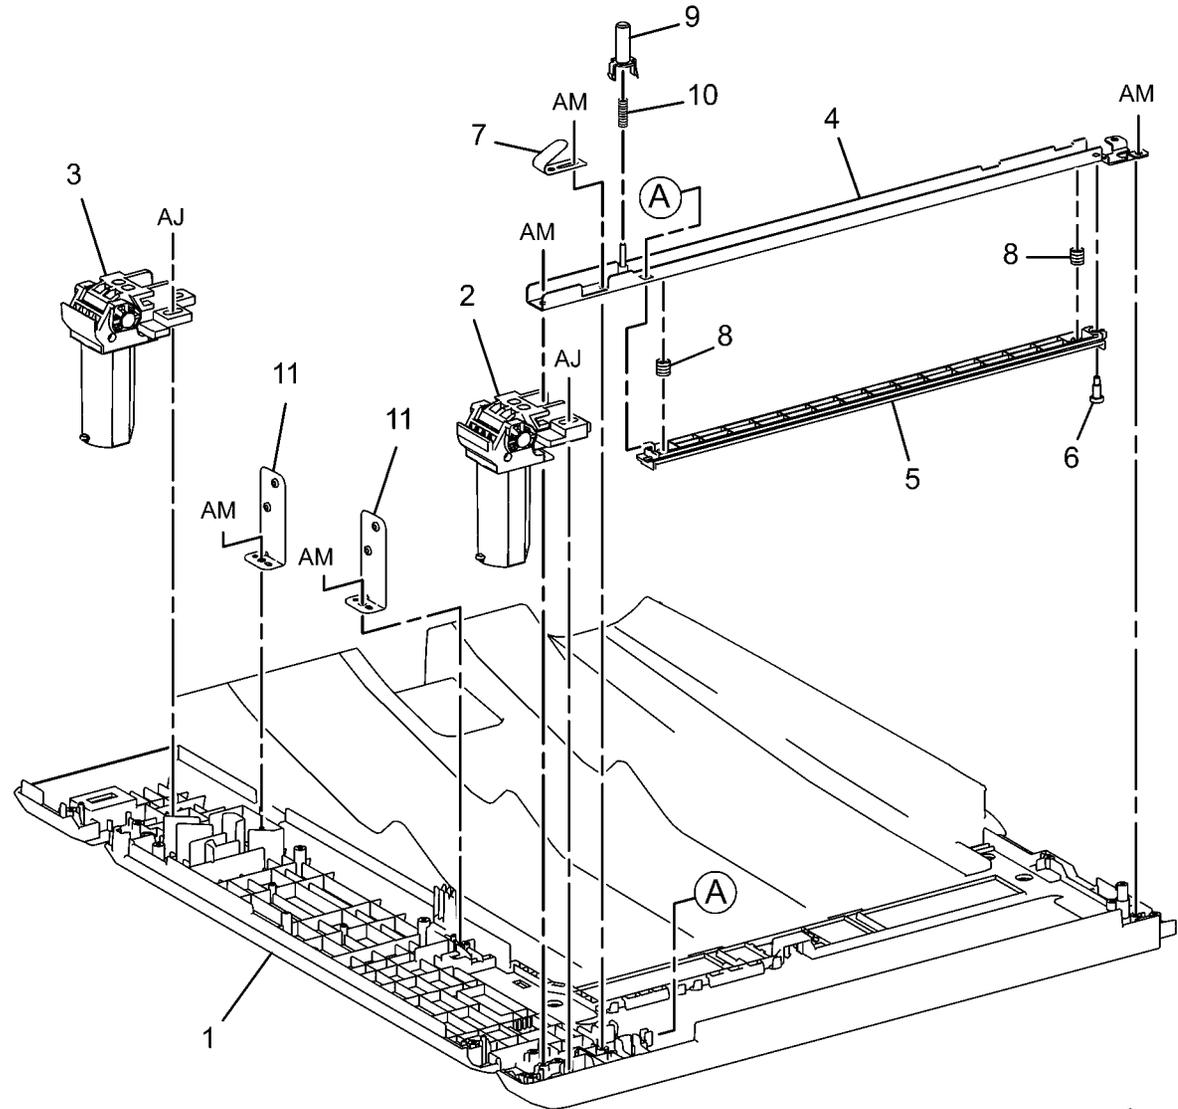
PL 51.3 Base Frame

Item	Part	Description
1	-	Frame (P/O PL 51.1 Item 2)
2	036K91873	Left Counter Balance (REP 5.7)
3	036K91921	Right Counter Balance (REP 5.8)
4	-	Tie Plate (P/O PL 51.1 Item 2)
5	054K41230	CVT Chute
6	826E45980	Stud Screw
7	-	Ground Plate (P/O PL 51.1 Item 2)
8	809E86290	CVT Spring
9	019E73462	Floating Holder
10	809E89310	Floating Spring
11	-	Bracket (P/O PL 51.1 Item 2)

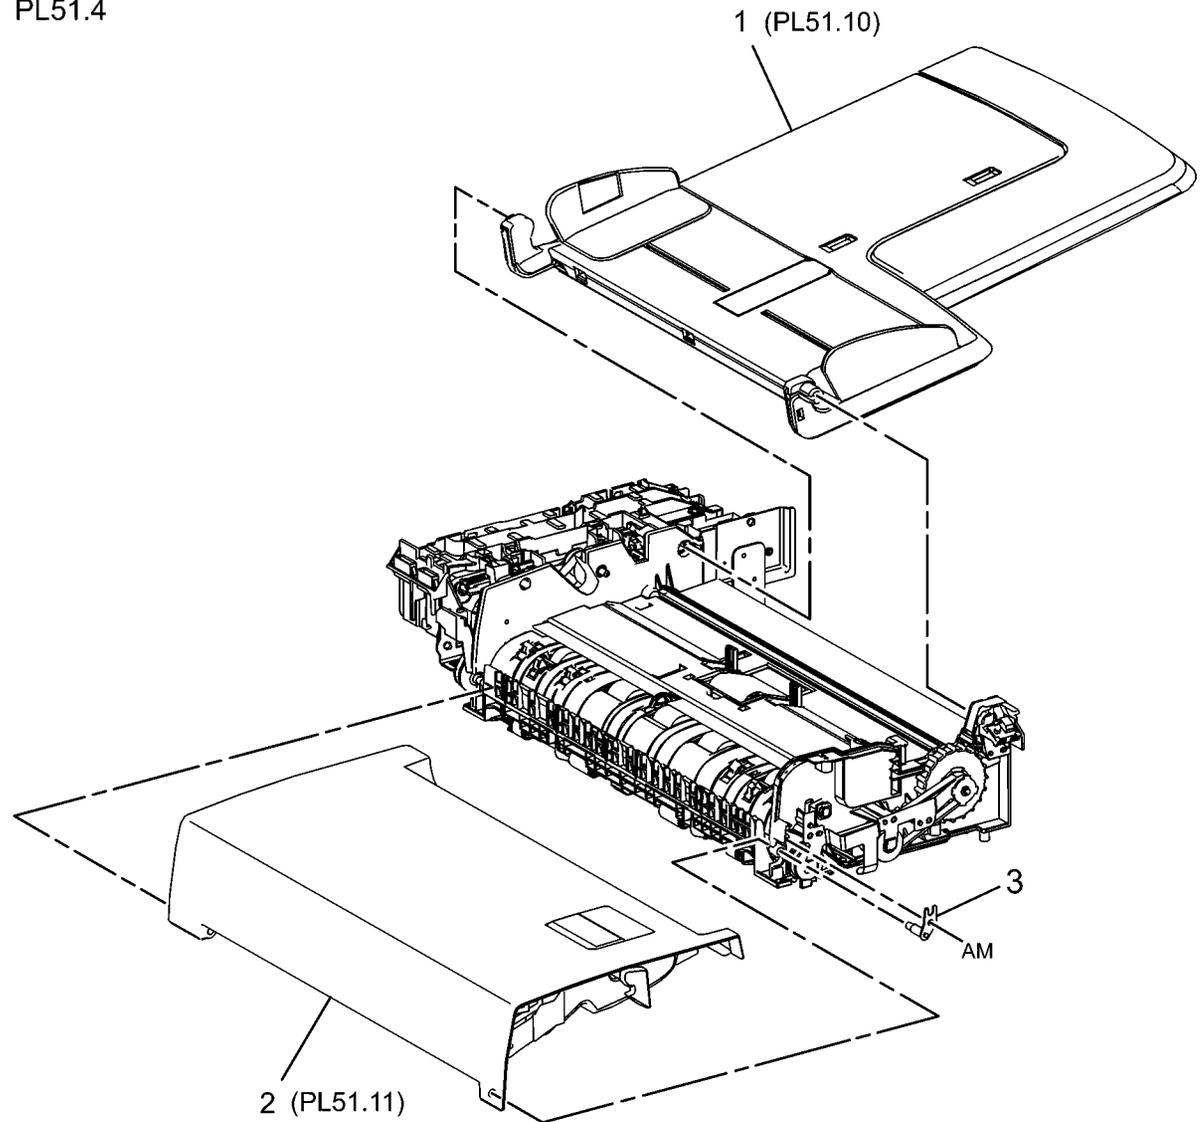
PL 51.4 Document Tray

Item	Part	Description
1	050K64252	Document Tray Assembly (REP 5.9)
2	059K65063	Top Cover (REP 5.10)
3	—	Stud Bracket (P/O PL 51.1 Item 2)
