WorkCentre 5335 Family Service Documentation

705P01303

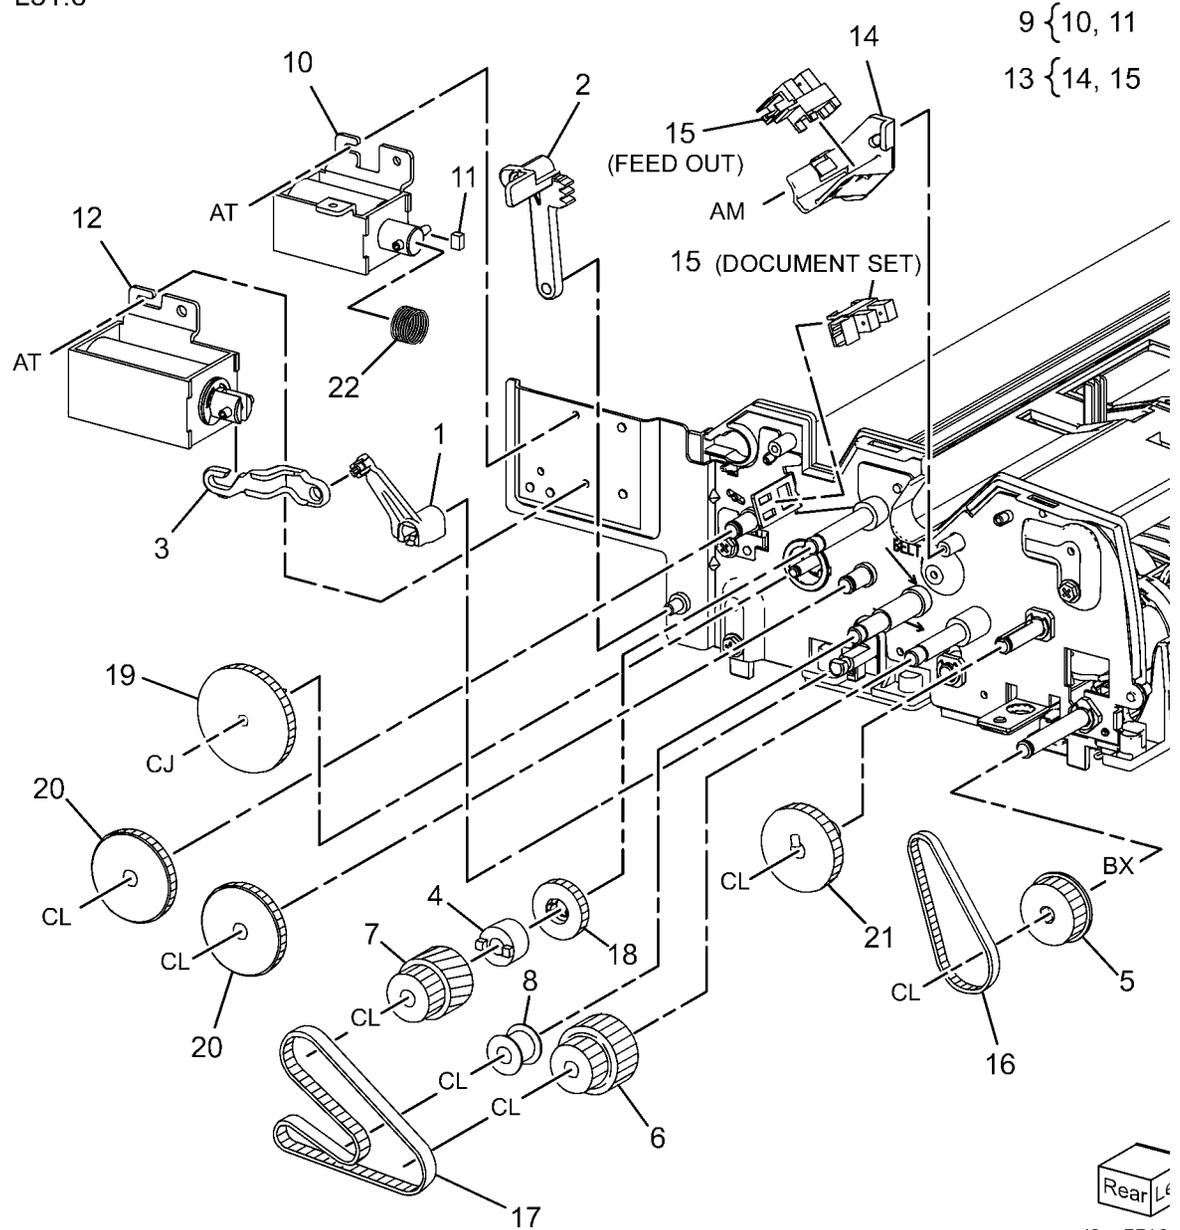
PL 51.6 DADF Drives (2 of 2)

Item	Part	Description
1	011E22861	Nip Lever
2	012E17151	Stopper Link
3	012E17161	Release Link
4	019K10320	Brake
5	020E46551	Registration Roll Pulley
6	020E46561	Pulley Gear
7	020E46571	Pulley Gear
8	059E98620	Roll
9	121K46620	Gate Solenoid
10	-	Gate Solenoid (P/O PL 51.6 Item 9)
11	-	Cushion (P/O PL 51.6 Item 9)
12	121K43660	Exit Nip Release Solenoid
13	130K73000	Feed Out Sensor Assembly
14	-	Sensor Bracket (P/O PL 51.6 Item 13)
15	930W00121	Feed Out Sensor, Document Set Sensor
16	423W06555	Belt
17	423W31354	Belt
18	807E26971	Gear
19	807E26981	Exit Roll Gear
20	807E26991	Gear
21	807E27011	Take Away Roll Gear
22	809E86320	Spring

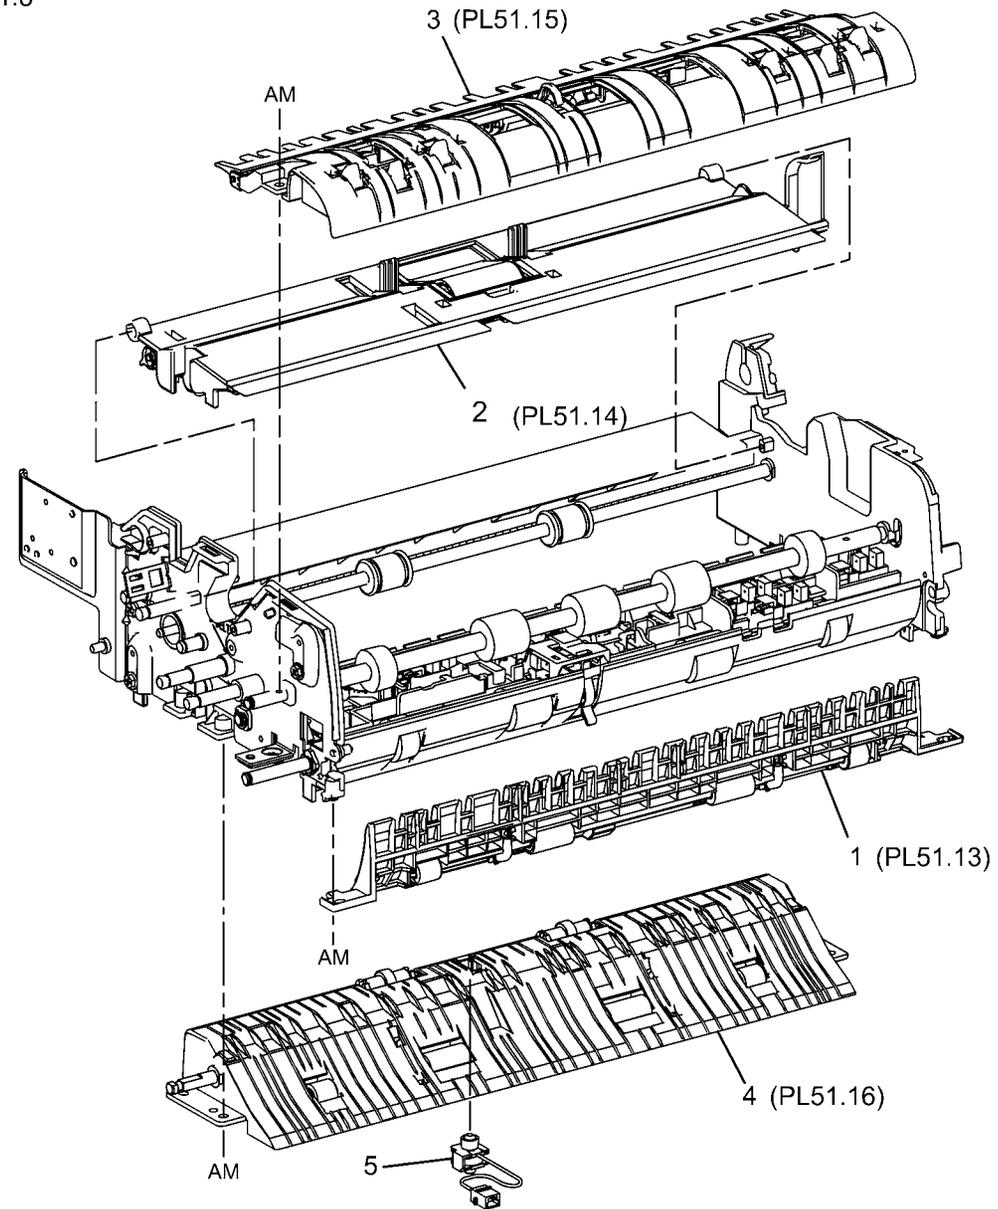
PL 51.8 Registration, Retard, Invert, Output Chutes

Item	Part	Description
1	054K39700	Registration Chute (REP 5.14)
2	054K44171	Retard Chute (REP 5.15)
3	054K41044	Invert Chute (REP 5.15)
4	054K41050	Output Chute
5	-	Stamp Solenoid (Not Spared)

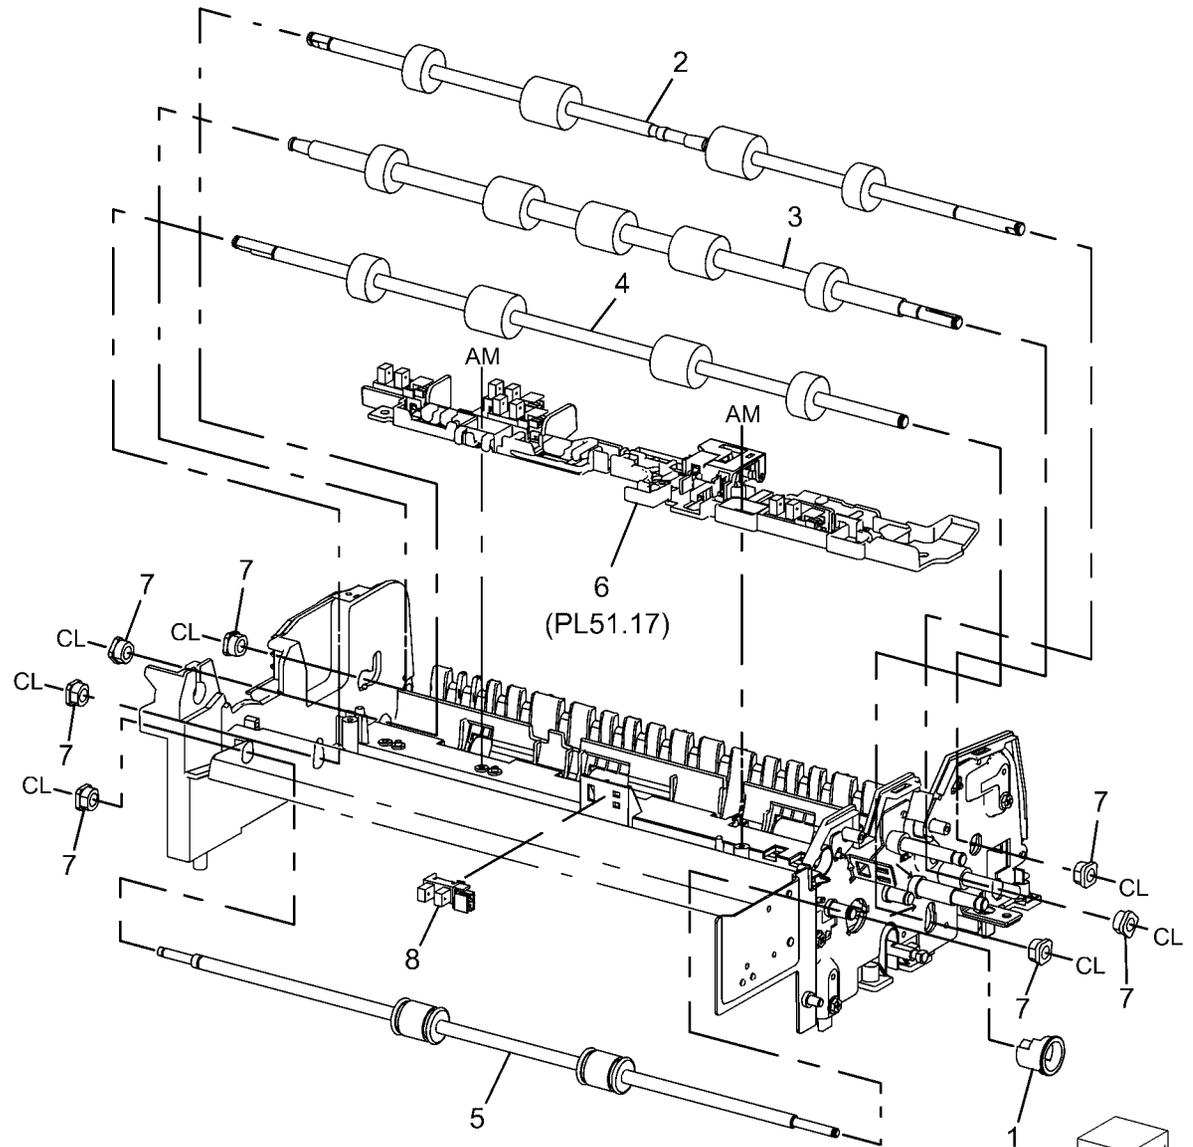
PL 51.9 Roll, Sensor Bracket

Item	Part	Description
1	-	Bearing (Not Spared)
2	059K65081	Registration Roll
3	-	Take Away Roll (Not Spared) (REP 5.16)
4	-	Output Roll (Not Spared)
5	-	Exit Roll (Not Spared)
6	068K69460	Sensor Bracket Assembly (REP 5.17)
7	-	Bearing (Not Spared)
8	930W00121	Invert Sensor

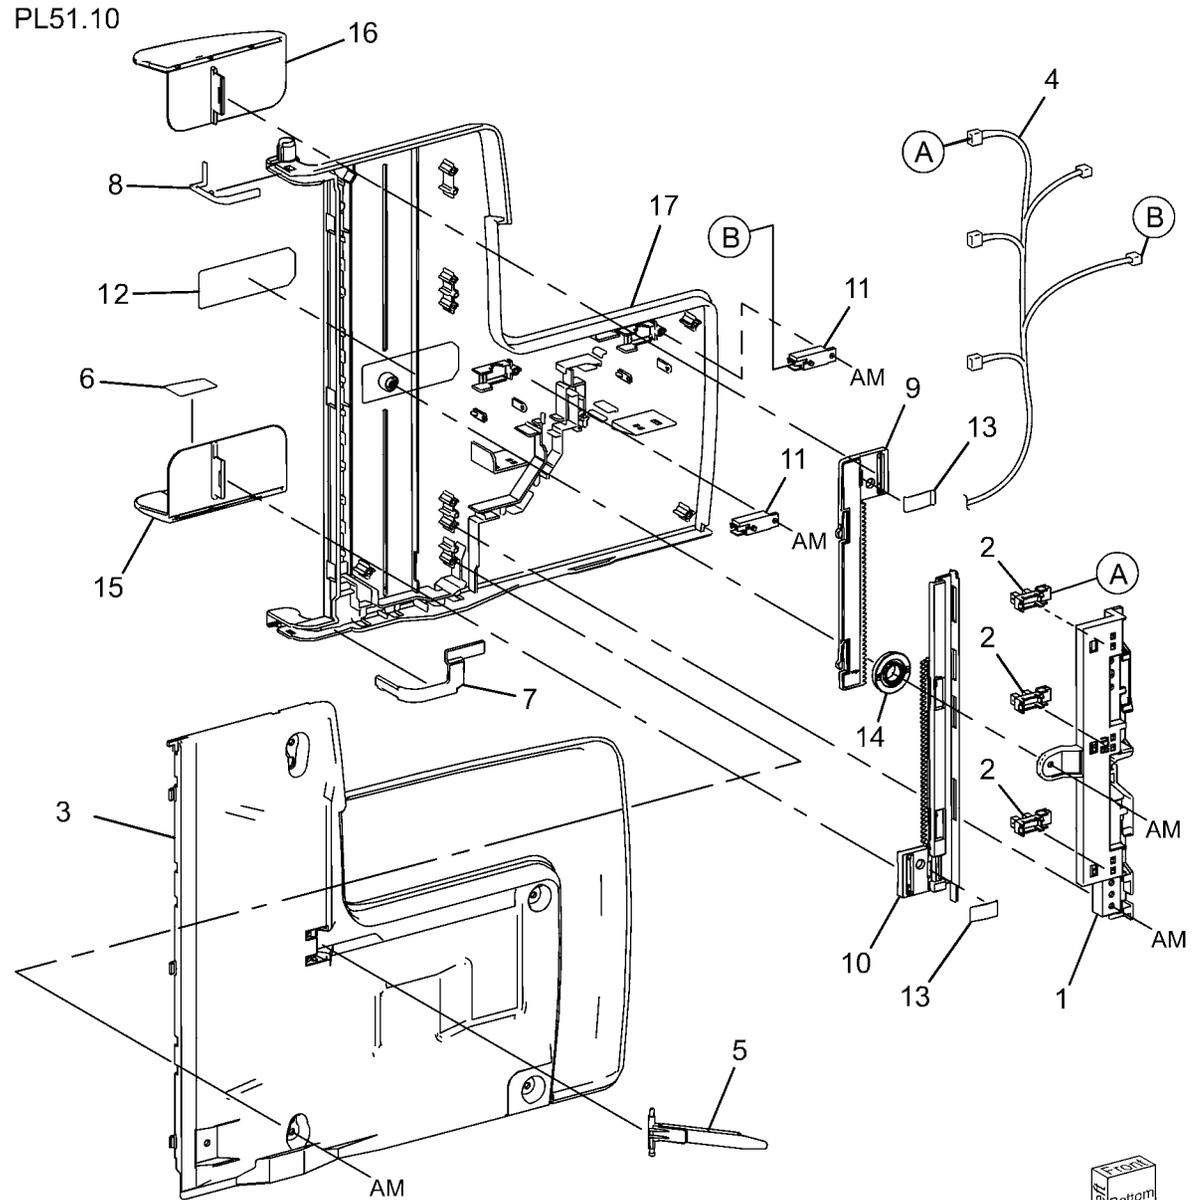
PL 51.10 Document Tray

Item	Part	Description
1	-	Sensor Bracket (P/O PL 51.4 Item 1)
2	930W00121	Tray Guide Set Sensor 1, Sensor 2, Sensor 3
3	-	Tray Cover (P/O PL 51.4 Item 1)
4	-	Tray Wire Harness (P/O PL 51.4 Item 1)
5	032K05861	Guide
6	-	Max Label (Not Spared)
7	-	Harness Cover (P/O PL 51.4 Item 1)
8	-	Harness Cover (P/O PL 51.4 Item 1)
9	-	Front Gear Rack (P/O PL 51.4 Item 1)
10	-	Rear Gear Rack (P/O PL 51.4 Item 1)
11	930W00241	Size Sensor 1, Size Sensor 2
12	-	Instruction Label (Not Spared)
13	-	Rack Spring (P/O PL 51.4 Item 1)
14	-	Pinion Gear (P/O PL 51.4 Item 1)
15	-	Side Guide (P/O PL 51.4 Item 1)
16	-	Side Guide (P/O PL 51.4 Item 1)
17	-	Upper Tray (P/O PL 51.4 Item 1)

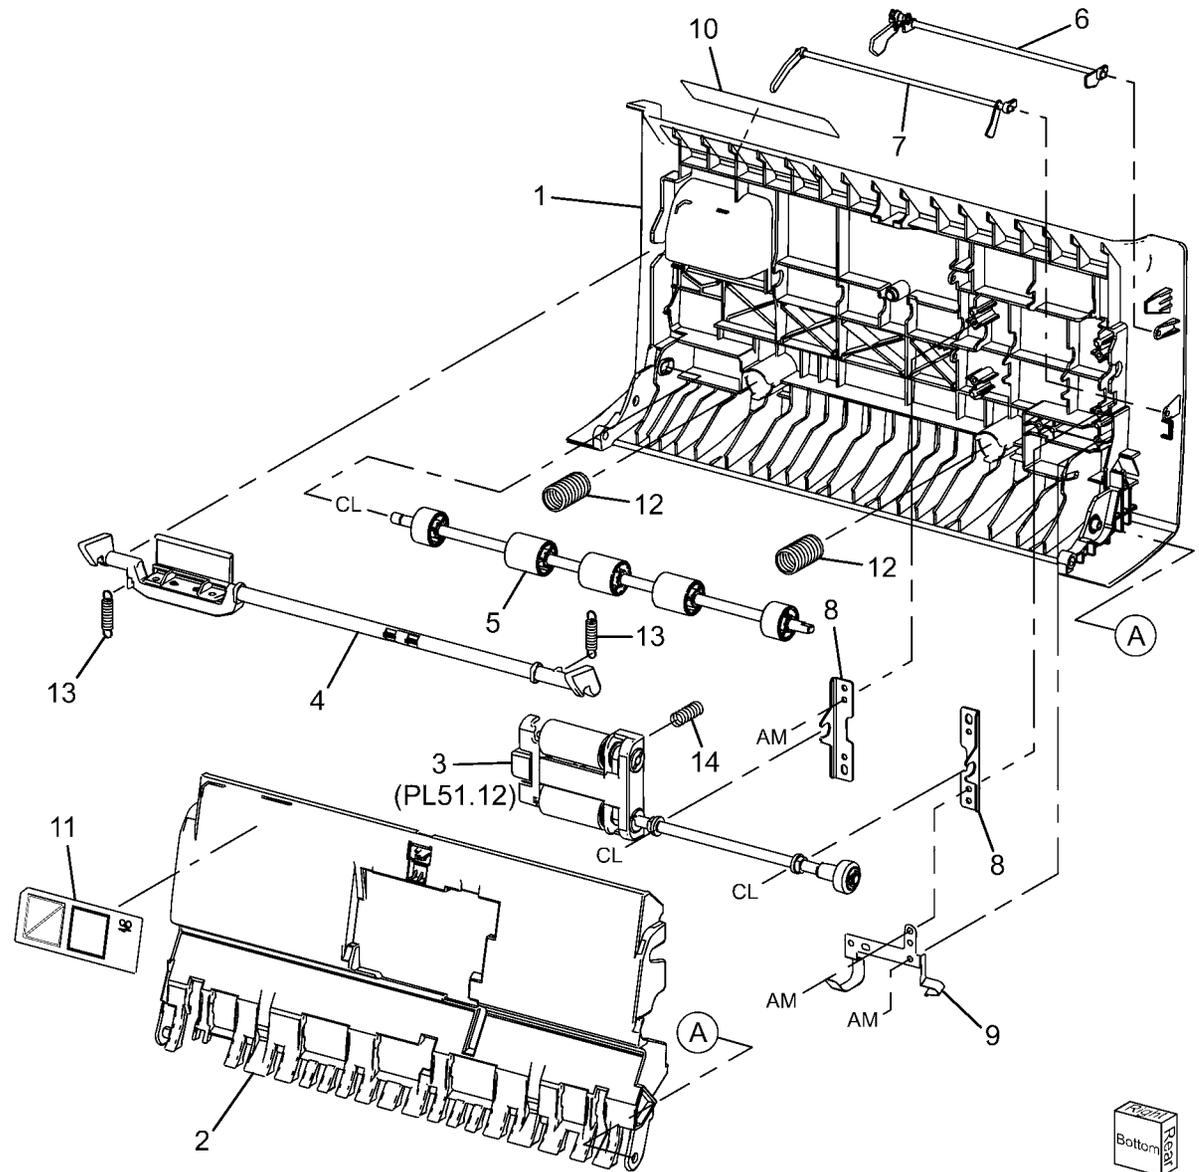
PL 51.11 Top Cover

Item	Part	Description
1	-	Top Cover (P/O PL 51.4 Item 2)
2	-	Upper Feed Chute (P/O PL 51.4 Item 2)
3	059K65070	Upper Feeder (REP 5.5)
4	011K03520	Lever Latch
5	059K61230	Take Away Pinch Roll
6	120K92500	Document Set Actuator
7	120E32200	Feed Out Actuator
8	-	Bracket (P/O PL 51.4 Item 2)
9	-	Ground Plate (P/O PL 51.4 Item 2)
10	897E24010	Size Label
11	897E24000	Jam Label
12	-	Spring (Not Spared)
13	-	Spring (Not Spared)
14	-	Spring (Not Spared)

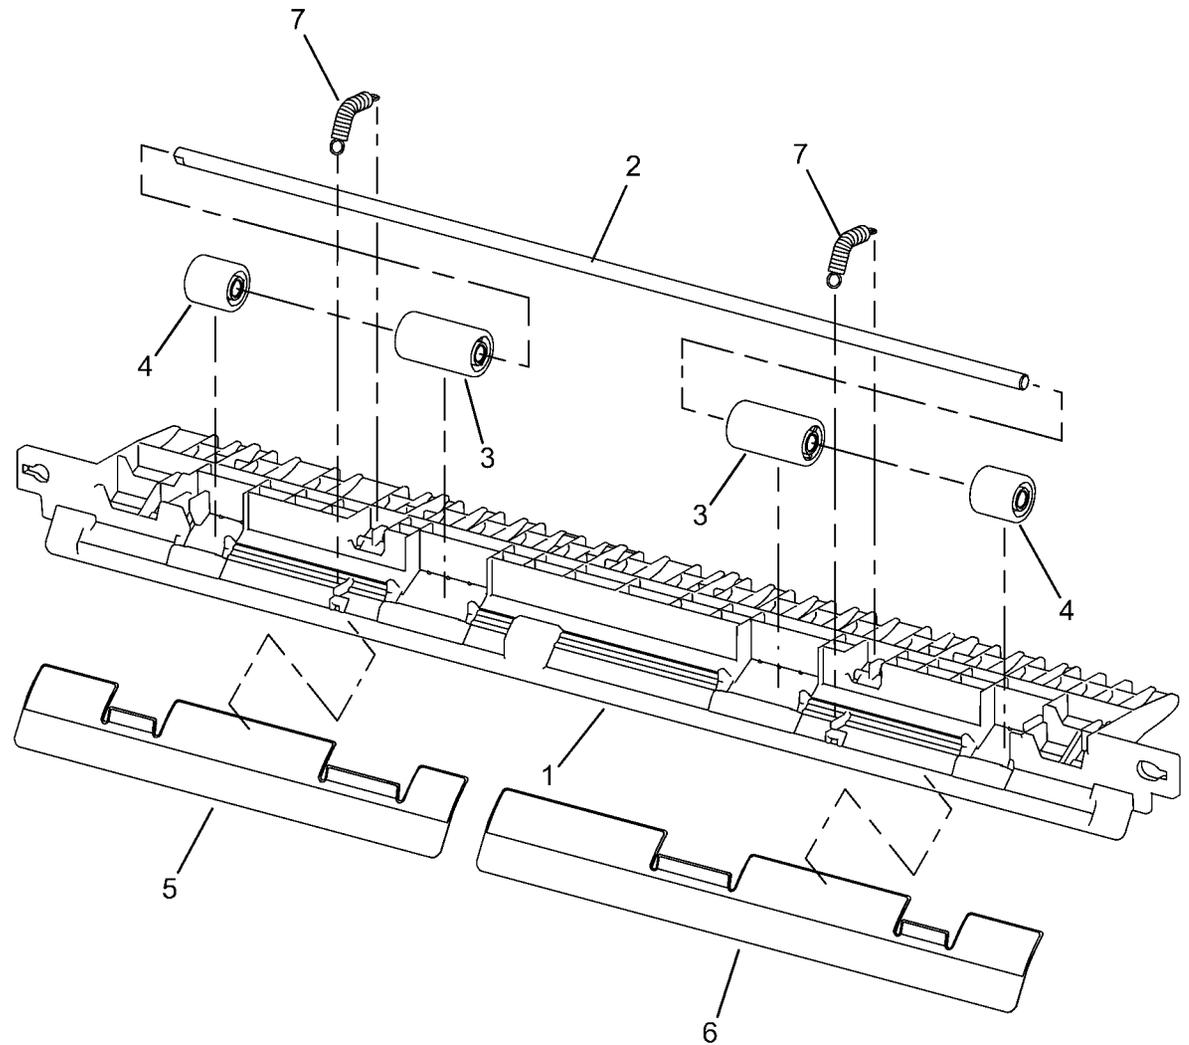
PL 51.13 Registration Chute

Item	Part	Description
1	-	Registration Chute (P/O PL 51.8 Item 1)
2	-	Pinch Shaft (P/O PL 51.8 Item 1)
3	-	Registration Wide Pinch Roll (P/O PL 51.8 Item 1)
4	-	Registration Short Pinch Roll (P/O PL 51.8 Item 1)
5	-	Seal (P/O PL 51.8 Item 1)
6	-	Seal (P/O PL 51.8 Item 1)
7	-	Spring (P/O PL 51.8 Item 1)

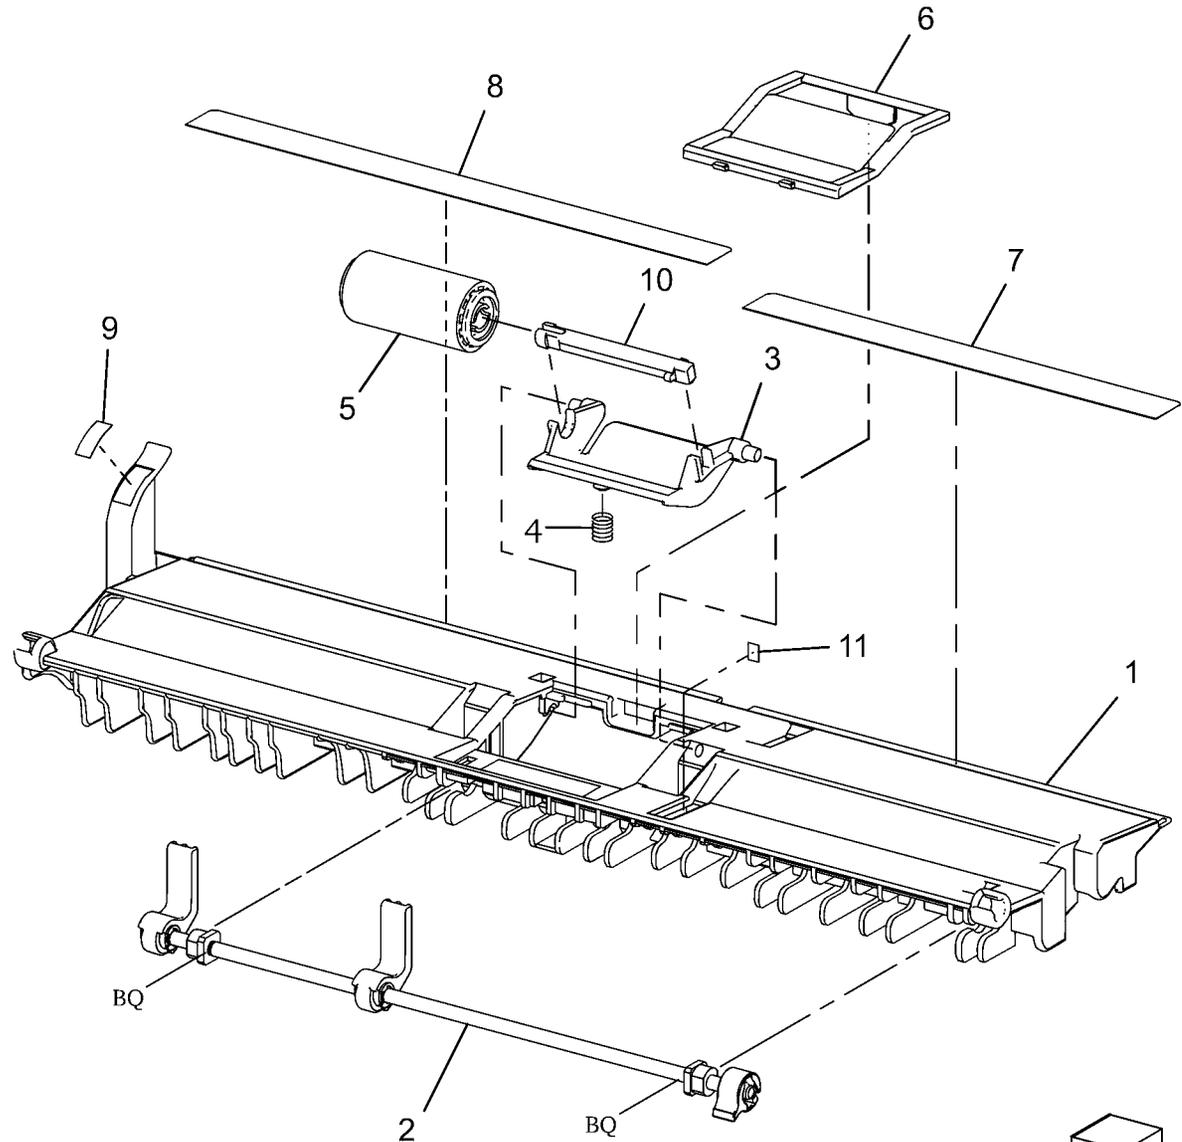
PL 51.14 Retard Chute

Item	Part	Description
1	-	Chute (P/O PL 51.8 Item 2)
2	-	Set Gate (P/O PL 51.8 Item 2)
3	-	Housing (P/O PL 51.8 Item 2)
4	-	Spring (P/O PL 51.8 Item 2)
5	-	Retard Roll (P/O PL 51.8 Item 2) (REP 5.19)
6	848K43600	Retard Roll Cover
7	-	Seal (P/O PL 51.8 Item 2)
8	-	Seal (P/O PL 51.8 Item 2)
9	-	Label (P/O PL 51.8 Item 2)
10	-	Shaft (P/O PL 51.12 Item 11)
11	-	Pad (P/O PL 51.8 Item 2)

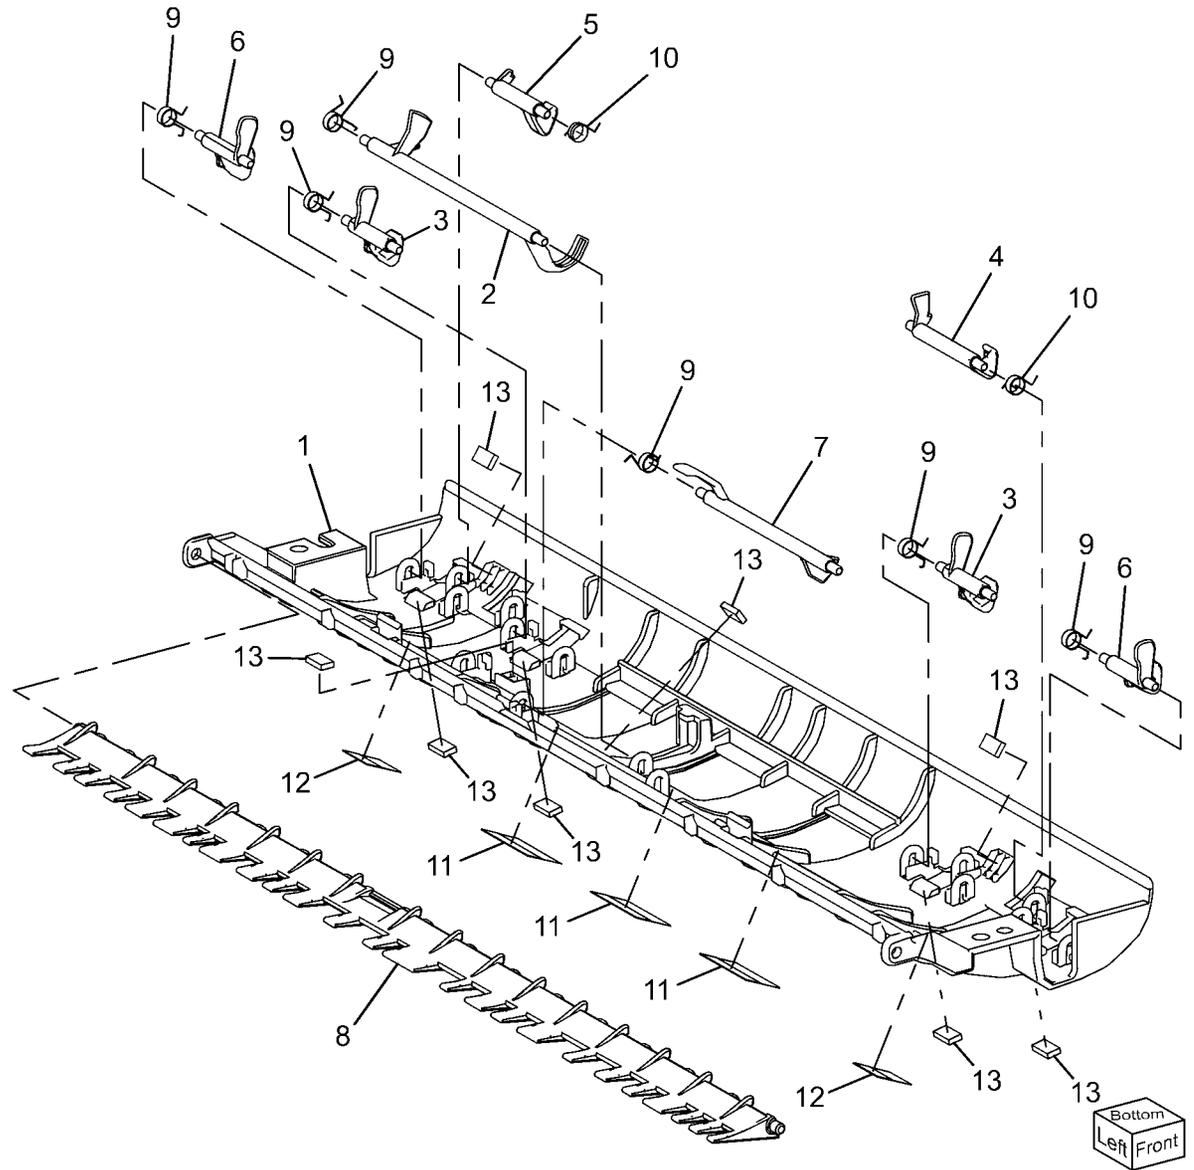
PL 51.15 Invert Chute

Item	Part	Description
1	-	Invert Chute (P/O PL 51.8 Item 3)
2	-	Pre Registration Actuator (P/O PL 51.8 Item 3)
3	-	Actuator (Aps 1) (P/O PL 51.8 Item 3)
4	-	Actuator (Aps 2) (P/O PL 51.8 Item 3)
5	-	Actuator (Aps 2) (P/O PL 51.8 Item 3)
6	-	Actuator (Aps 3) (P/O PL 51.8 Item 3)
7	-	Invert Actuator (P/O PL 51.8 Item 3)
8	-	Invert Gate (P/O PL 51.8 Item 3)
9	-	Spring (P/O PL 51.8 Item 3)
10	-	Spring (P/O PL 51.8 Item 3)
11	-	Seal (P/O PL 51.8 Item 3)
12	-	Seal (P/O PL 51.8 Item 3)
13	-	Pad (P/O PL 51.8 Item 3)

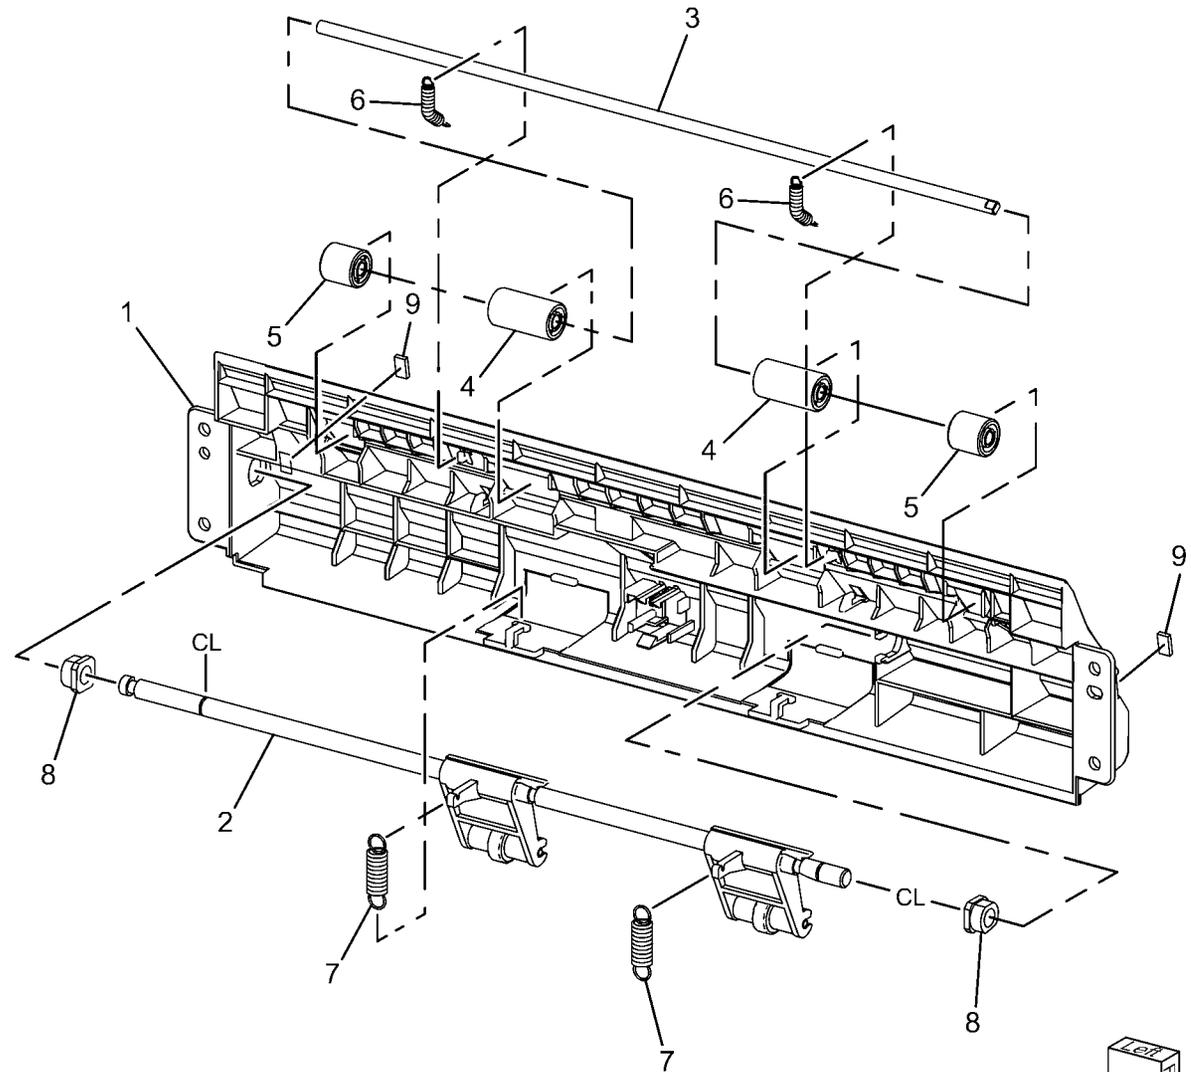
PL 51.16 Output Chute

Item	Part	Description
1	-	Chute (P/O PL 51.8 Item 4)
2	-	Exit Pinch Roll (P/O PL 51.8 Item 4)
3	-	Pinch Shaft (P/O PL 51.8 Item 4)
4	-	Wide Registration Pinch Roll (P/O PL 51.8 Item 4)
5	-	Short Registration Pinch Roll (P/O PL 51.8 Item 4)
6	-	Spring (P/O PL 51.8 Item 4)
7	-	Spring (P/O PL 51.8 Item 4)
8	-	Bearing (P/O PL 51.8 Item 4)
9	-	Pad (P/O PL 51.8 Item 4)

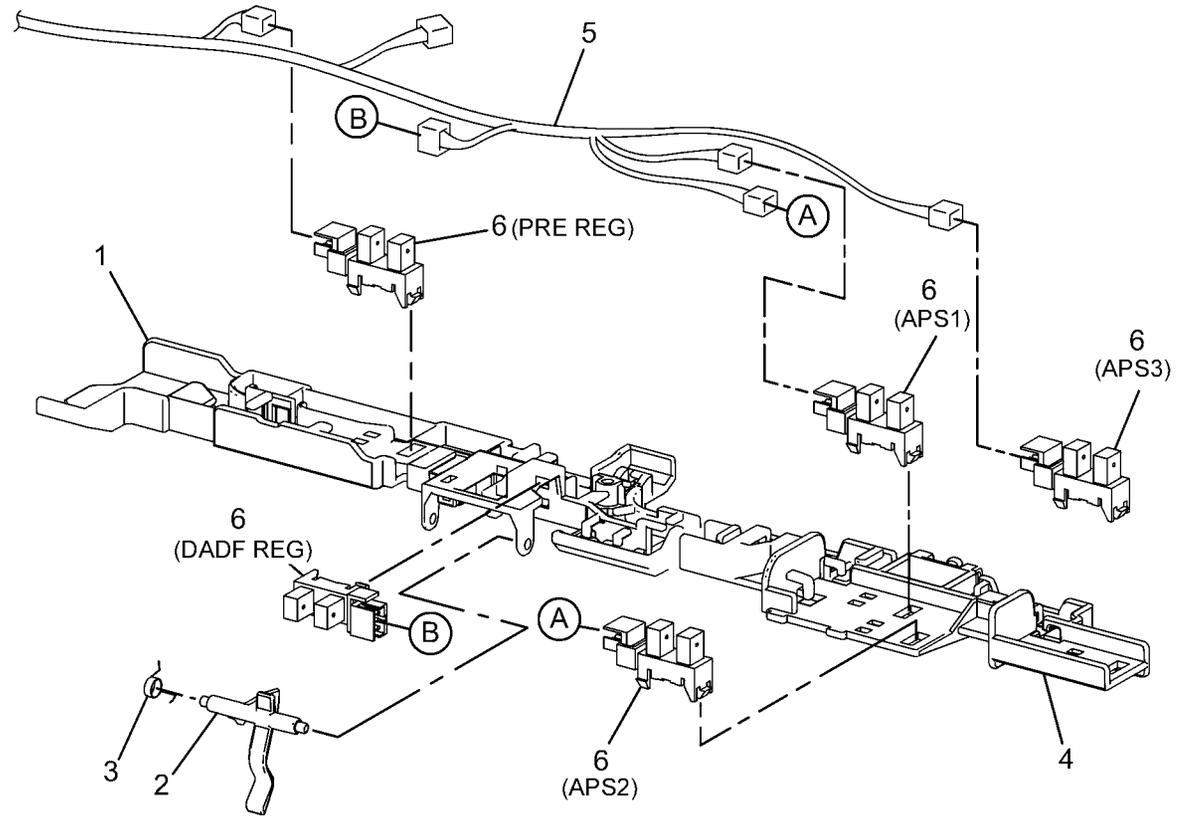
PL 51.17 Sensor Bracket

Item	Part	Description
1	-	Sensor Housing (P/O PL 51.4 Item 1)
2	120E31741	Registration Actuator
3	-	Spring (P/O PL 51.4 Item 1)
4	-	Sensor Guide (P/O PL 51.4 Item 1)
5	-	Wire Harness (Not Spared)
6	930W00121	APS Sensor 1, APS Sensor 2, APS Sensor 3, Registration Sensor, Pre Registration Sensor

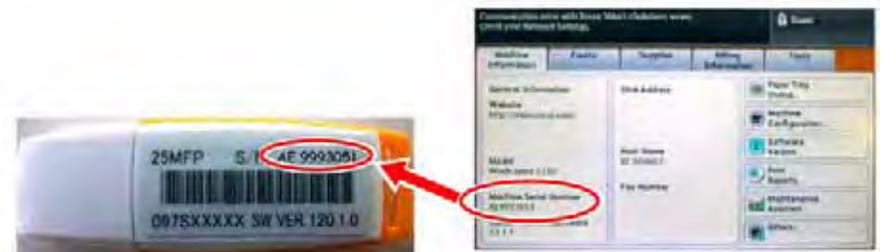
Figure 13 Serial Number information

1. With the machine still operating, remove the USB dongle from the USB port.
2. Select the **Machine Status** button on the Control Panel and locate the Machine Serial Number on the lower, left part of the screen. Record this number on the dongle label (Figure 13). The space is limited so make certain to record at least the last five digits of the Serial Number.

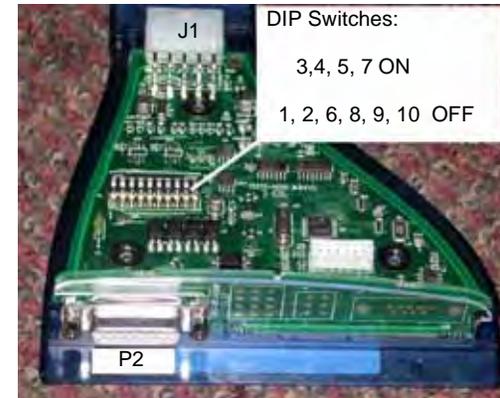
1. Perform internal dip switch setup for the Bear DCS6061 FDI:
 - a. Remove the 3 Phillips screws on under side of the FDI.
 - b. Remove top cover to gain access to the internal DIP switches.
 - c. Set switches as shown in [Figure 1](#).

Figure 1 FDI Switches

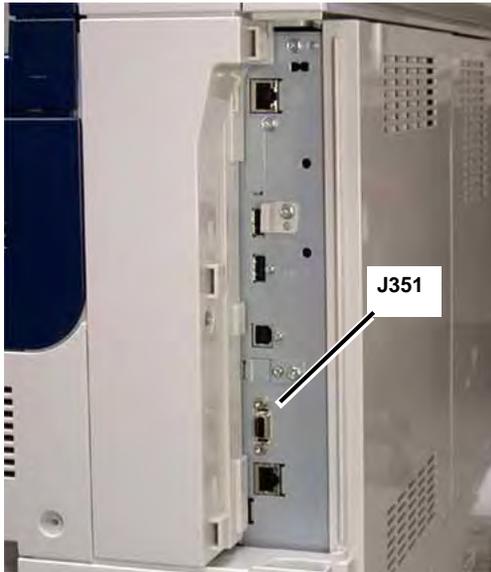
- d. Reassemble the FDI.
2. Connect the FDI:
 - a. Switch off the power.
 - b. Connect the cable from [P/J351](#) on the ESS PWB Chassis ([Figure 2](#)) to [J1](#) on the FDI.

Figure 2 ESS PWB Connection

P/J344	Figure 14	6	ESS PWB
P/J345	Figure 14	7	ESS PWB
P/J346	Figure 14	8	ESS PWB
P/J351	Figure 14	4	ESS PWB
P/J352	Figure 12	4	FAX
P/J352	Figure 14	18	ESS PWB
P/J353	Figure 12	5	
P/J355	Figure 12	1	
P/J356	Figure 12	6	
P/J363	Figure 12	2	
P/J364	Figure 12	3	
P/J380	Figure 14	9	
P/J390	Figure 14	19	ESS PWB
P/J400	Figure 15	1	MCU PWB

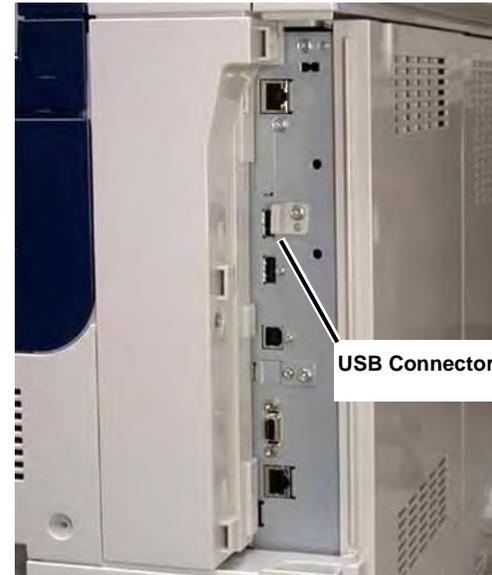
- b. Insert the USB Flash Drive into the USB connector on the Control Panel (if available) or the ESS PWB Chassis (Figure 1).
The FAX Cable (if present) should remain plugged in during the SW upgrade. This enables the FAX software to be upgraded using this procedure.

Figure 1 ESS PWB Connection

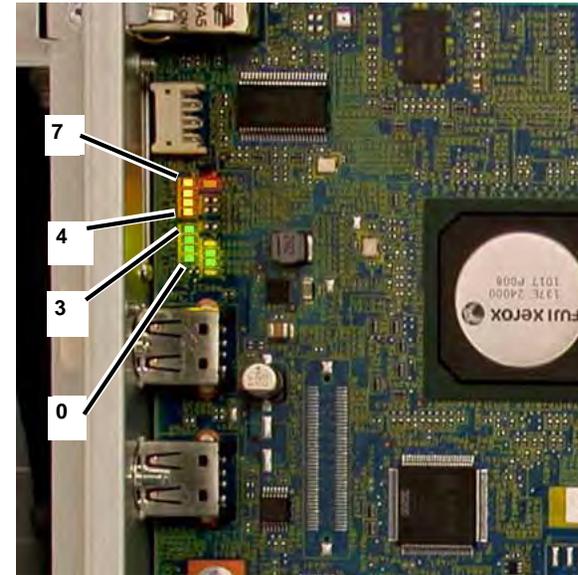
Check the ESS PWB LED ON/OFF states, refer to (Figure 1) and (Table 1) LED Legend.

ESS PWB LED's 0, 1, 2, 3 are Green; 4, 5, 6, 7 are Yellow.

Figure 1 ESS PWB On/Off LED's

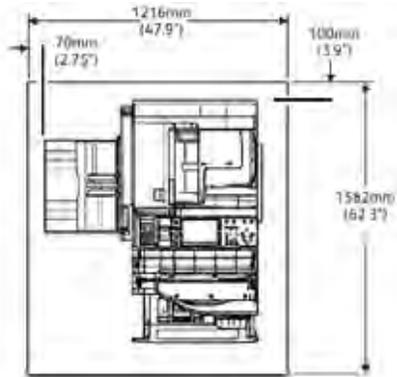
Basic Model : Installation Space (W x D): 1216 x 1582mm (47.9 x 63.2 inches) (Figure 1)

Figure 1 Base Model

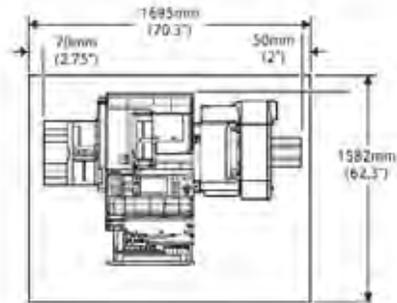
With Office Finsher LX: Installation Space (W x D): 1695 x 1582mm (70.3 x 62.3 inches) (Figure 2)

Figure 2 w/ LX Finisher

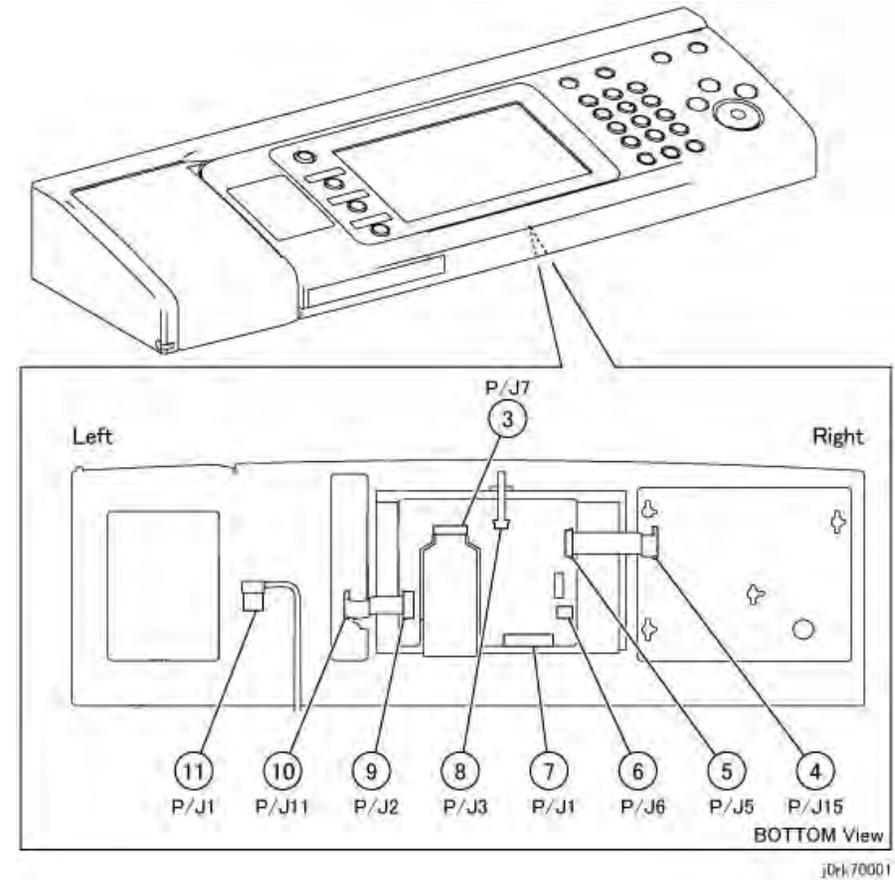
Figure 1 UI

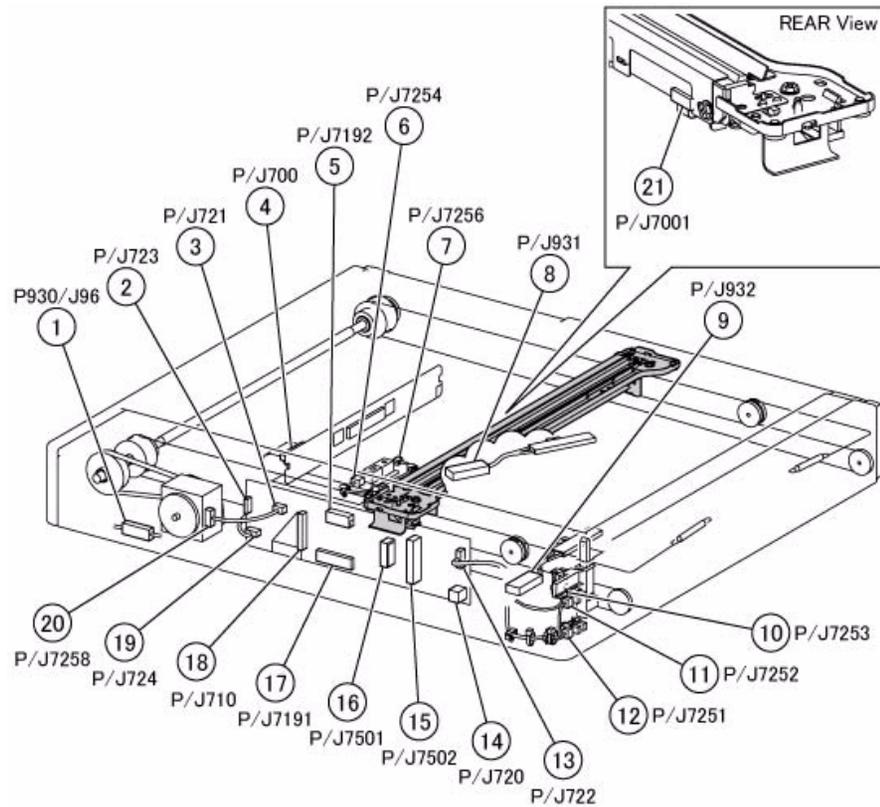
Figure 4 IIT

P/J No.	Figure No.	Item No.	Remarks (where to connect)
P/J772	Figure 3	6	DADF PWB
P/J773	Figure 2	7	
P/J774	Figure 2	9	
P/J775	Figure 2	8	
P/J776	Figure 3	8	
P/J777	Figure 3	7	
P/J778	Figure 2	15	
P/J779	Figure 2	14	
P/J780	Figure 2	16	
P/J791	Figure 2	19	
P/J903	Figure 17	1	Relay Connector
P930/J96	Figure 4	1	
P/J931	Figure 4	8	Heater
P/J932	Figure 4	9	Heater
P/J999	Figure 5	16	CRUM PWB
P/J1310	Figure 14	1	
P/J1323	Figure 14	11	ESS PWB
P/J1324	Figure 14	13	
P/J7001	Figure 4	21	LED Lamp
P/J7191	Figure 4	17	IIT
P/J7192	Figure 4	5	IIT
P/J7251	Figure 4	12	IIT
P/J7252	Figure 4	11	
P/J7253	Figure 4	10	
P/J7254	Figure 4	6	
P/J7256	Figure 4	7	
P/J7258	Figure 4	20	Carriage Motor
P/J7501	Figure 4	16	IIT
P/J7502	Figure 4	15	IIT

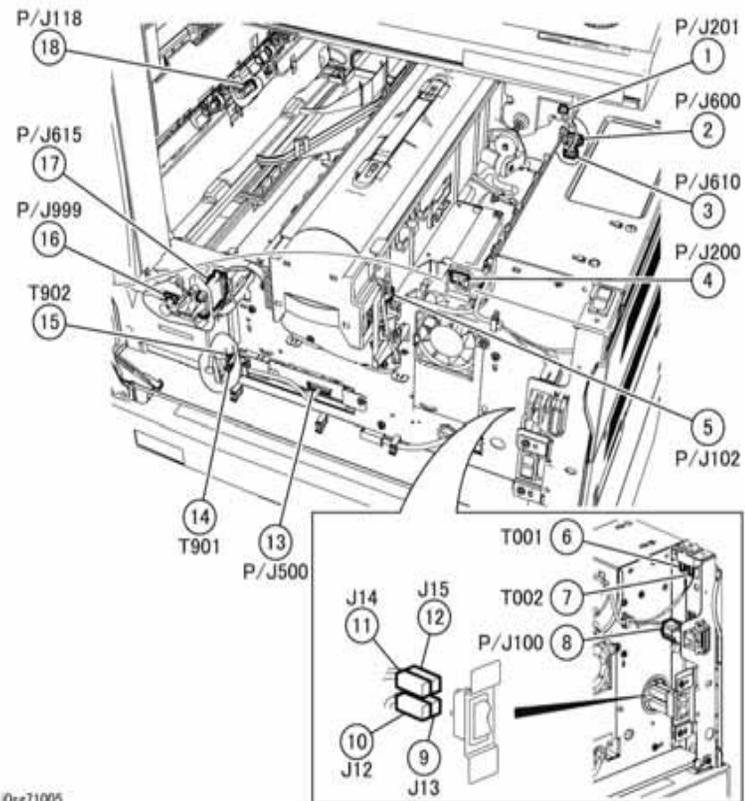
Figure 5 Main Power/FrontCover Interlock Switch

P/J115	Figure 9	5	Exit Sensor 2
P/J115	Figure 20	3	Tray 4 Nudger Level Sensor
P/J116	Figure 9	4	L/H Upper Cover Interlock Switch
P/J116	Figure 20	5	Tray 4 Feed Out Sensor
P/J117	Figure 9	1	Face up Tray Detect Switch
P/J118	Figure 5	18	
P/J119	Figure 9	7	OCT Tray Home Sensor
P/J121	Figure 7	3	Registration Sensor
P/J122	Figure 18	1	Tray 1 Paper Size Sensor
P/J123	Figure 18	2	Tray 2 Paper Size Sensor
P131	Figure 11		Fuser
P132	Figure 11		Fuser
P/J140	Figure 19		ROS Unit
P/J150	Figure 7	2	Hum & Temp Sensor
P/J160	Figure 19		ROS Unit
P/J170	Figure 19		ROS Unit
P/J200	Figure 5	4	CRU Fan
P/J201	Figure 5	1	Drum/IBT Drive Motor
P/J202	Figure 13	4	Drum/IBT Drive Motor

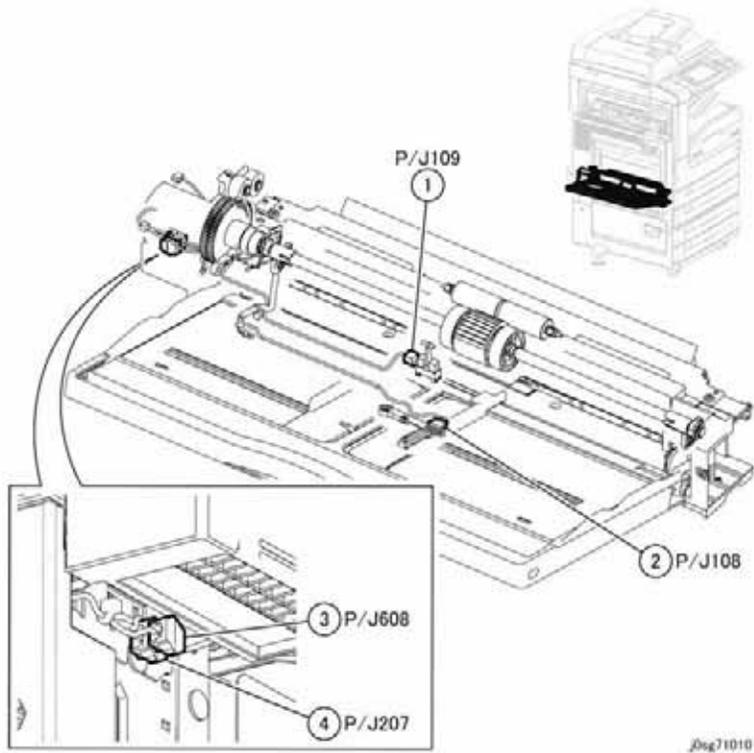
Figure 6 MSI

P/J No.	Figure No.	Item No.	Remarks (where to connect)
P/J94	Figure 17	18	GFI Chassis
P/J95	Figure 17	17	GFI Chassis
P/J102	Figure 20	4	Tray 3 Paper Size Sensor
P/J102	Figure 5	5	Toner Crum PWB
P/J108	Figure 6	2	MSI Paper Size Sensor
P/J108	Figure 10	1	Duplex Cover Open Switch
P/J103	Figure 20	11	Tray 4 Paper Size Sensor
P/J109	Figure 6	1	MSI No Paper Sensor
P/J109	Figure 10	2	Duplex Path Sensor
P/J104	Figure 20	10	Tray Module L/H Cover Switch
P/J105	Figure 8	3	Tray 1 Nudger Level Sensor
P/J106	Figure 8	2	Tray 1 No Paper Sensor
P/J107	Figure 8	2	Tray 1 Pre Feed Sensor
P/J108	Figure 20	6	Tray 3 Feed Out Sensor
P/J110	Figure 8	5	Feed Out Sensor 2
P/J110	Figure 20	2	Tray 3 No Paper Sensor
P/J111	Figure 8	6	L/H Lower Cover Interlock Switch
P/J111	Figure 20	3	Tray 3 Nudger Level Sensor
P/J112	Figure 8	3	Tray 2 Nudger Level Sensor
P/J113	Figure 8	2	Tray 2 No Paper Sensor
P/J114	Figure 8	4	Tray 2 Pre Feed Sensor
P/J114	Figure 20	2	Tray 4 No Paper Sensor

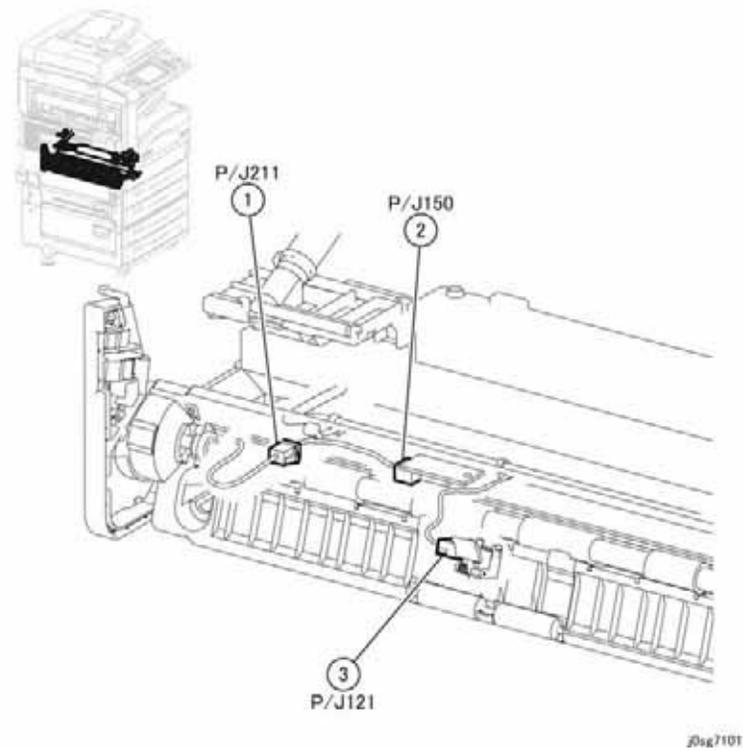
Figure 7 Registration

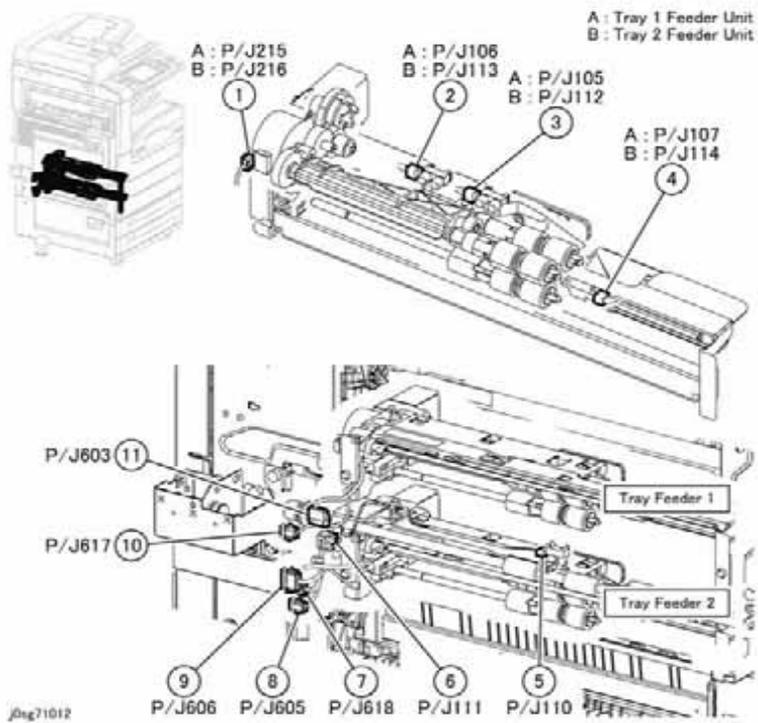
Figure 8 Tray1/2 Feeder

P/J555	Figure 21	2	Tray Module PWB
P/J602	Figure 10	4	Relay Connector
P/J603	Figure 8	11	Relay Connector
P/J605	Figure 8	8	Relay Connector
P/J606	Figure 8	9	Relay Connector
P/J607	Figure 9	9	Relay Connector
P/J613	Figure 13		Relay Connector
P/J614	Figure 6	14	Relay Connector
P/J614	Figure 11	1	Fuser

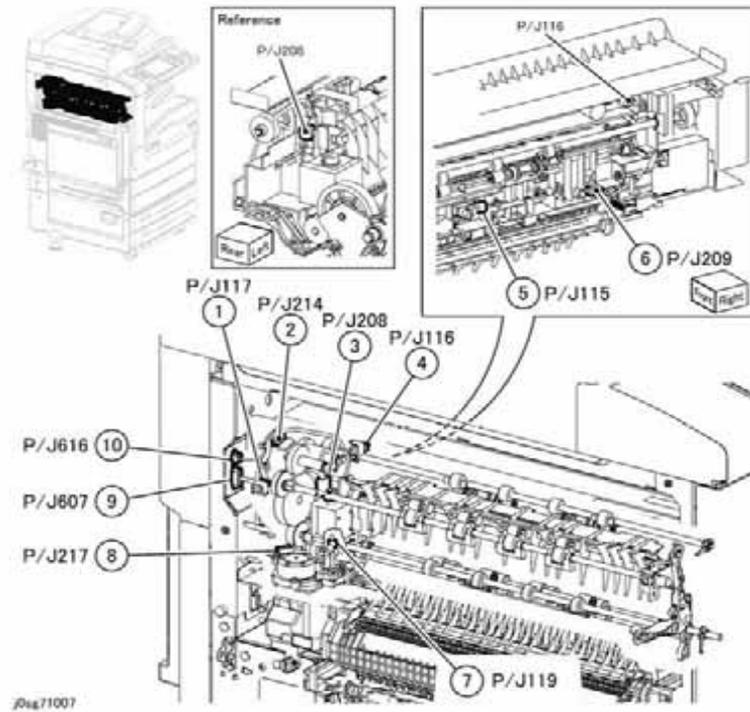
Figure 9 L/H Side

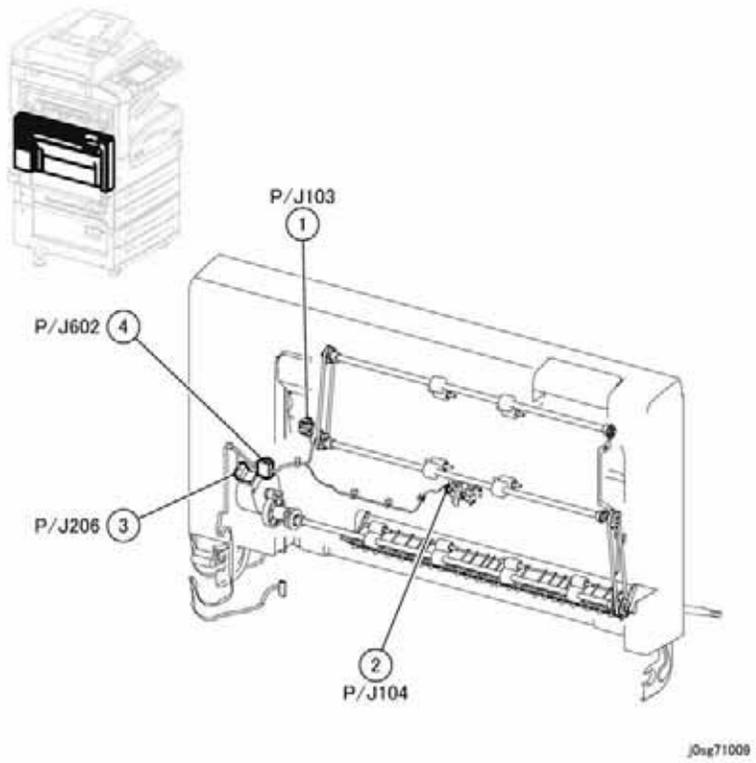
Figure 10 Duplex Cover

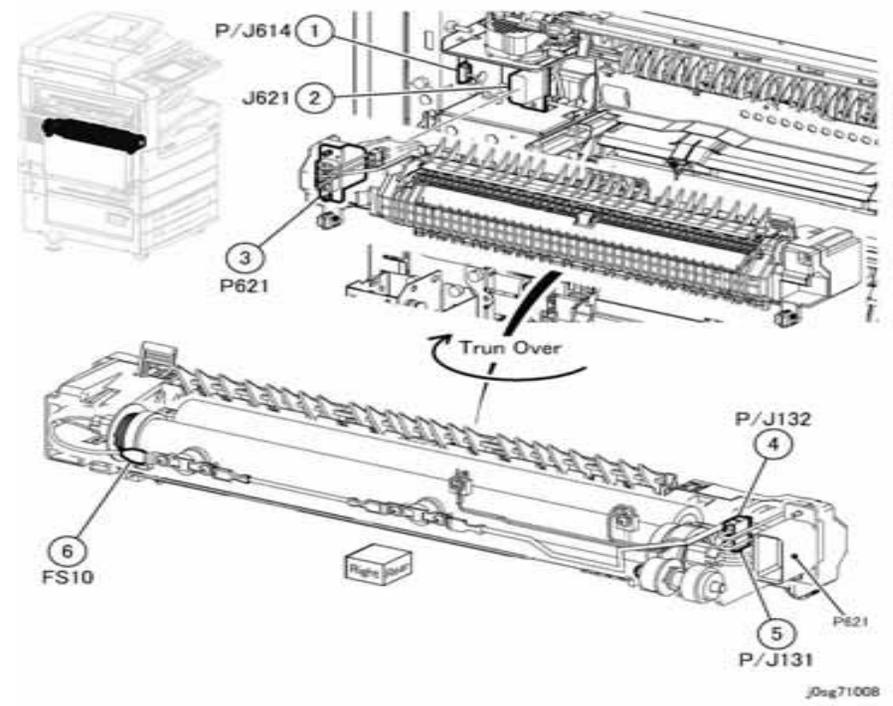
Figure 11 Fuser
