WorkCentre 5335 Family Service Documentation

705P01303

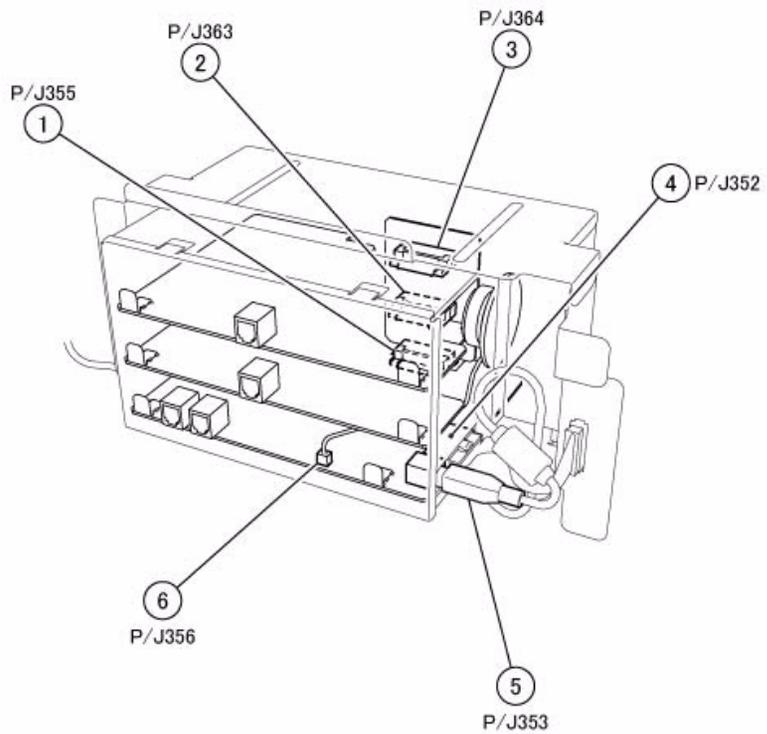
Figure 12 Fax

P/J344	Figure 14	6	ESS PWB
P/J345	Figure 14	7	ESS PWB
P/J346	Figure 14	8	ESS PWB
P/J351	Figure 14	4	ESS PWB
P/J352	Figure 12	4	FAX
P/J352	Figure 14	18	ESS PWB
P/J353	Figure 12	5	
P/J355	Figure 12	1	
P/J356	Figure 12	6	
P/J363	Figure 12	2	
P/J364	Figure 12	3	
P/J380	Figure 14	9	
P/J390	Figure 14	19	ESS PWB
P/J400	Figure 15	1	MCU PWB

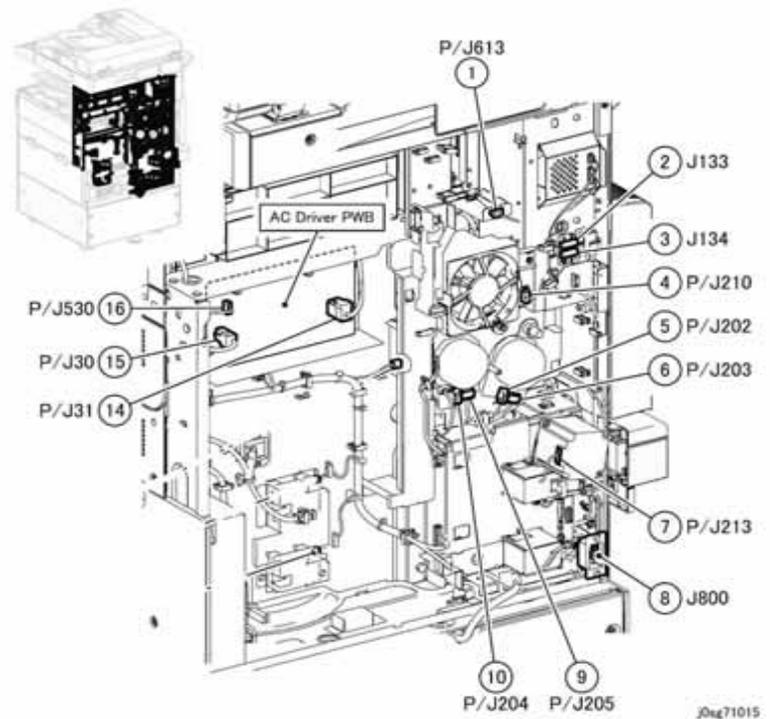
Figure 13 AC Driver PWB, Dev, Drive Motor

P/J19	Figure 17	9	GFI Chassis
P30	Figure 13	15	AC Driver PWB
P31	Figure 13	14	AC Driver PWB
P/J51	Figure 17	6	GFI Chassis
P/J52	Figure 17	13	GFI Chassis
P/J53	Figure 17	8	GFI Chassis
P/J80	Figure 17	11	GFI Chassis
P/J81	Figure 17	12	GFI Chassis
P/J90	Figure 17	20	GFI Chassis
P/J91	Figure 17	14	GFI Chassis
P/J92	Figure 17	15	GFI Chassis
P/J93	Figure 17	19	GFI Chassis

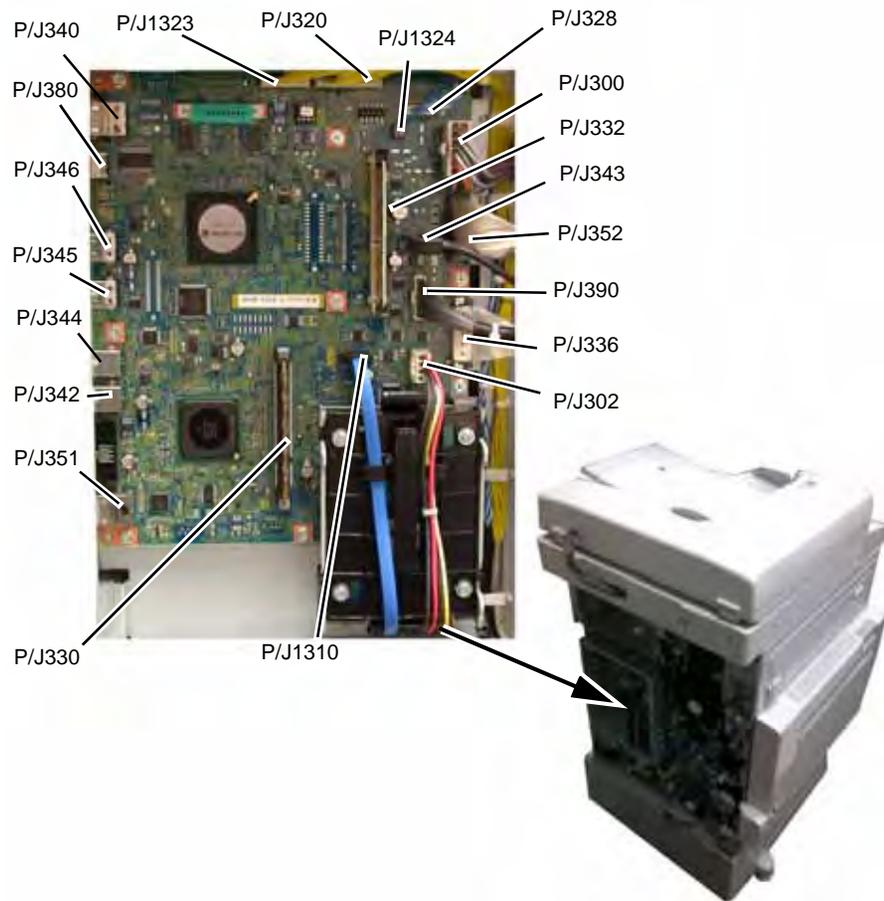
Figure 14 ESS

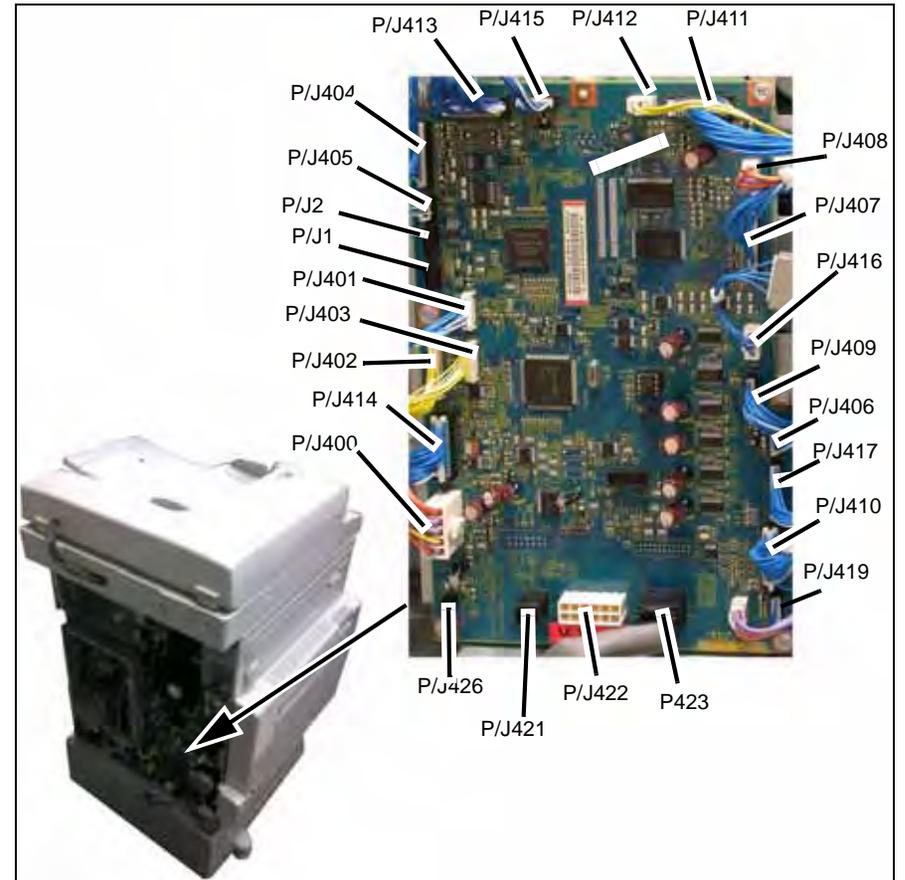
Figure 15 MCU PWB

P/J No.	Figure No.	Item No.	Remarks (where to connect)
P/J401	Figure 15	4	MCU PWB
P/J402	Figure 15	5	MCU PWB
P/J403	Figure 15	6	MCU PWB
P/J404	Figure 15	12	MCU PWB
P/J405	Figure 15	13	MCU PWB
P/J406	Figure 15	14	MCU PWB
P/J407	Figure 15	9	MCU PWB
P/J408	Figure 15	11	MCU PWB
P/J409	Figure 15	10	MCU PWB
P/J410	Figure 15	24	MCU PWB
P/J411	Figure 15	23	MCU PWB
P/J412	Figure 15	26	MCU PWB
P/J413	Figure 15	22	MCU PWB
P/J414	Figure 15	25	MCU PWB
P/J415	Figure 15	16	MCU PWB
P/J416	Figure 15	15	MCU PWB
P/J417	Figure 15	8	MCU PWB
P/J419	Figure 15	2	MCU PWB
P/J422	Figure 15	18	MCU PWB
P423	Figure 15	17	MCU PWB
P/J423	Figure 20	12	Relay Connector
P/J426	Figure 15	20	MCU PWB
P500	Figure 5	13	Main Power
P/J501	Figure 16	5	
P/J502	Figure 16	3	Main LVPS
P/J503	Figure 16	1	
P/J505	Figure 16	4	
P/J506	Figure 16	2	
P530	Figure 13	16	AC Driver PWB
P/J541	Figure 21	1	Tray Module PWB
P/J548	Figure 21	18	Tray Module PWB
P/J554	Figure 21	16	Tray Module PWB

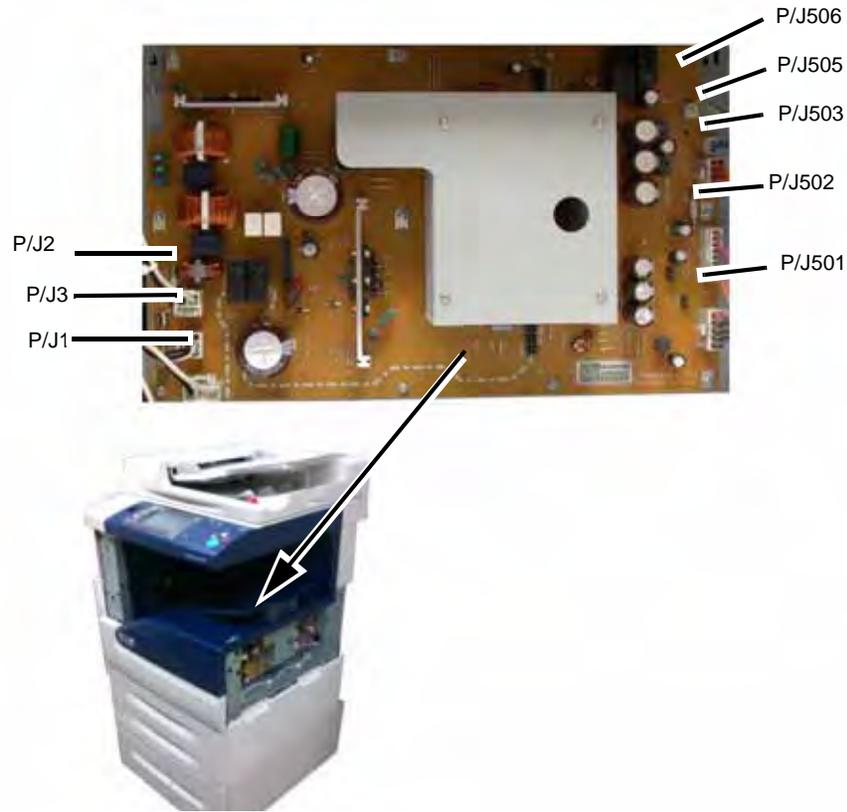
Figure 16 LVPS PWB

P/J No.	Figure No.	Item No.	Remarks (where to connect)
P620	Figure 19	1	ROS
F1	Figure 2	12	DADF
P1	Figure 15		MCU PWB
P/J1	Figure 1	7	Control Panel PWB
P/J1	Figure 1	11	USB(UI)
P/J1	Figure 16	9	Main Low Voltage Power Supply
F2	Figure 2	13	DADF
P2	Figure 15		MCU PWB
P/J2	Figure 1	9	Control Panel PWB
P/J2	Figure 16	7	Main Low Voltage Power Supply
P/J3	Figure 1	8	Control Panel PWB
P/J3	Figure 16	8	Main Low Voltage Power Supply
P/J5	Figure 1	5	PWB(UI)
P/J6	Figure 1	6	PWB(UI)
P/J7	Figure 1	3	PWB(DSP)
F10	Figure 11	9	Fuser
P/J10	Figure 17	4	GFI Breaker
P/J11	Figure 1	10	UI Function PWB
P/J11	Figure 17	5	GFI Breaker
P/J12	Figure 5	12	Main Power/FrontCover Interlock Switch
P/J13	Figure 5	11	Main Power/FrontCover Interlock Switch
P/J14	Figure 5	9	Main Power/FrontCover Interlock Switch
P/J15	Figure 1	4	UI 10Key PWB
P/J15	Figure 5	10	Main Power Switch
P/J16	Figure 17	2	GFI Chassis
P/J17	Figure 17	3	GFI Chassis
P/J18	Figure 17	7	GFI Chassis

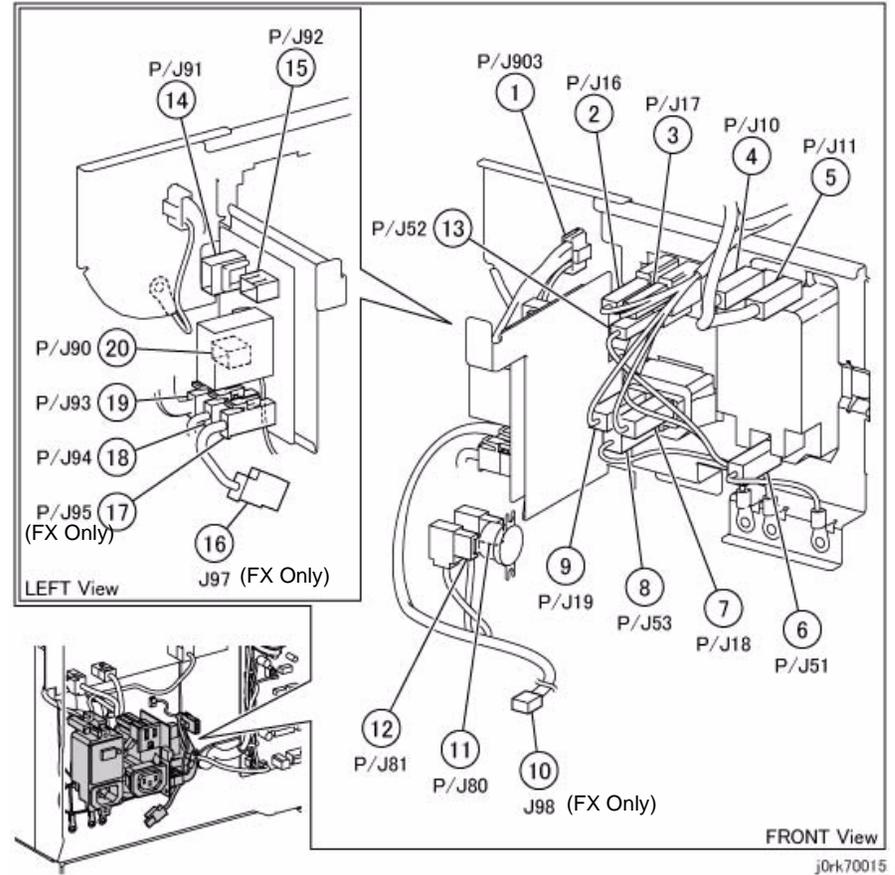
Figure 17 GFI Chassis

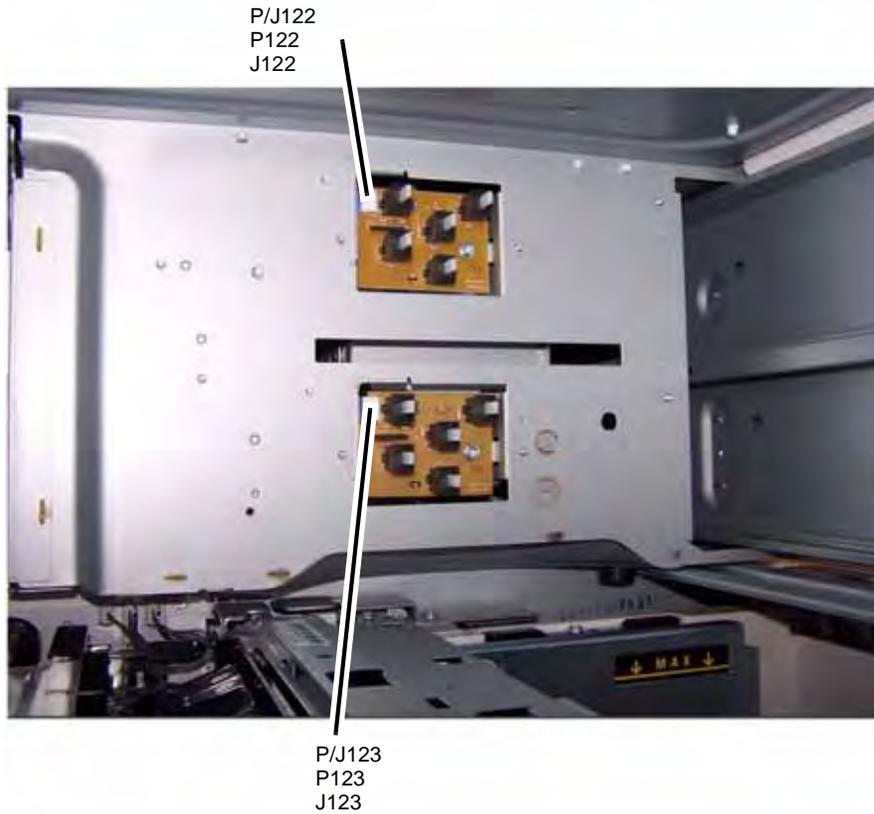
Figure 18 Tray 1 / Tray 2 Paper Size Sensor

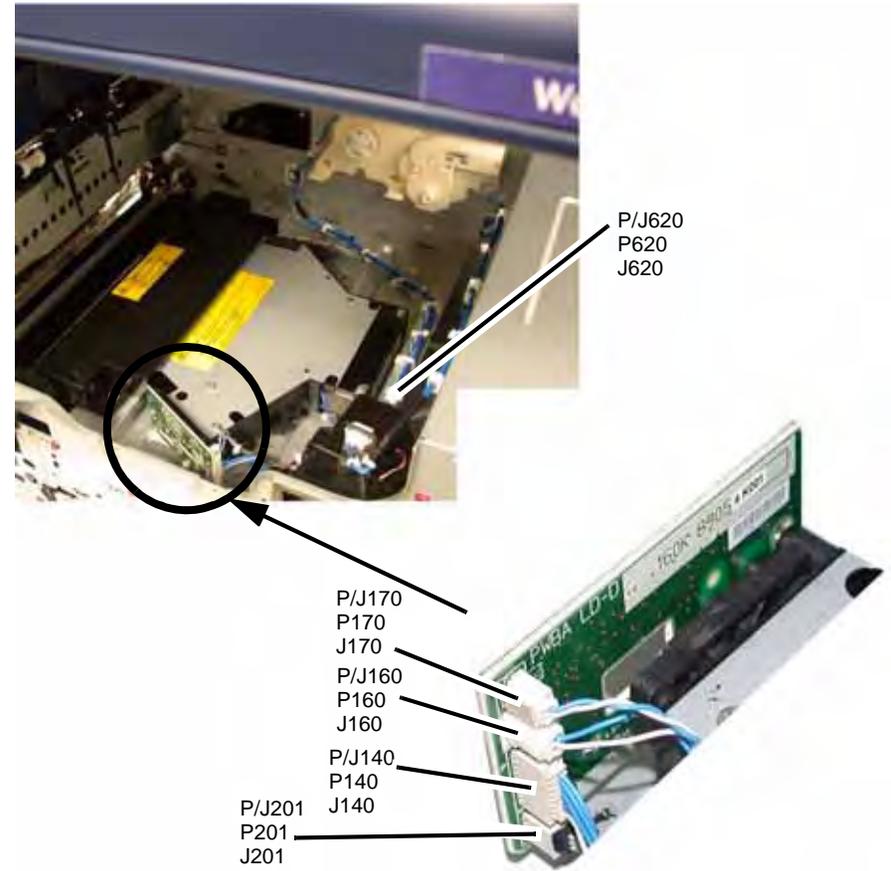
Figure 19 ROS

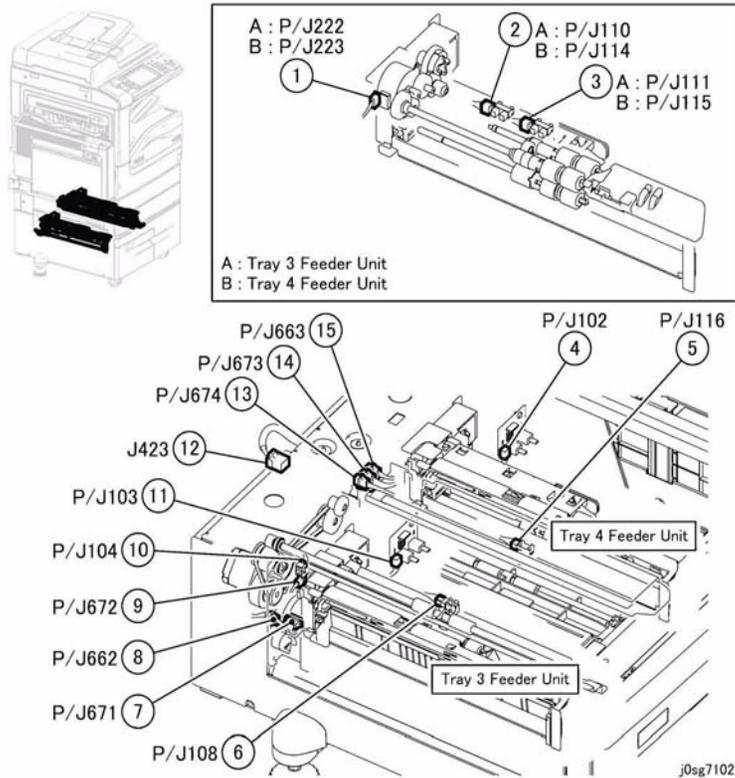
Figure 20 Tray 3/4 Feeder (TTM)

P/J No.	Figure No.	Item No.	Remarks (where to connect)
P/J94	Figure 17	18	GFI Chassis
P/J95	Figure 17	17	GFI Chassis
P/J102	Figure 20	4	Tray 3 Paper Size Sensor
P/J102	Figure 5	5	Toner Crum PWB
P/J108	Figure 6	2	MSI Paper Size Sensor
P/J108	Figure 10	1	Duplex Cover Open Switch
P/J103	Figure 20	11	Tray 4 Paper Size Sensor
P/J109	Figure 6	1	MSI No Paper Sensor
P/J109	Figure 10	2	Duplex Path Sensor
P/J104	Figure 20	10	Tray Module L/H Cover Switch
P/J105	Figure 8	3	Tray 1 Nudger Level Sensor
P/J106	Figure 8	2	Tray 1 No Paper Sensor
P/J107	Figure 8	2	Tray 1 Pre Feed Sensor
P/J108	Figure 20	6	Tray 3 Feed Out Sensor
P/J110	Figure 8	5	Feed Out Sensor 2
P/J110	Figure 20	2	Tray 3 No Paper Sensor
P/J111	Figure 8	6	L/H Lower Cover Interlock Switch
P/J111	Figure 20	3	Tray 3 Nudger Level Sensor
P/J112	Figure 8	3	Tray 2 Nudger Level Sensor
P/J113	Figure 8	2	Tray 2 No Paper Sensor
P/J114	Figure 8	4	Tray 2 Pre Feed Sensor
P/J114	Figure 20	2	Tray 4 No Paper Sensor

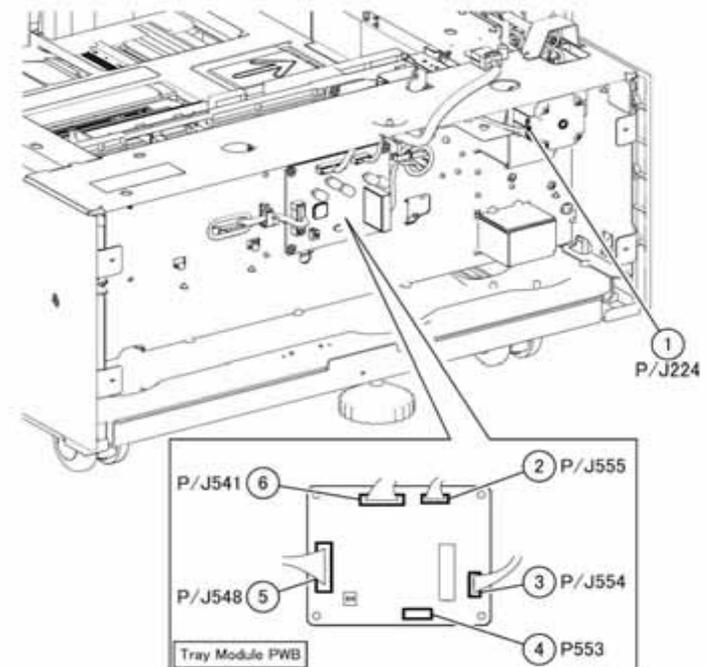
Figure 21 Tray3/4 Feeder, Tray Module PWB, TM Take Away Motor

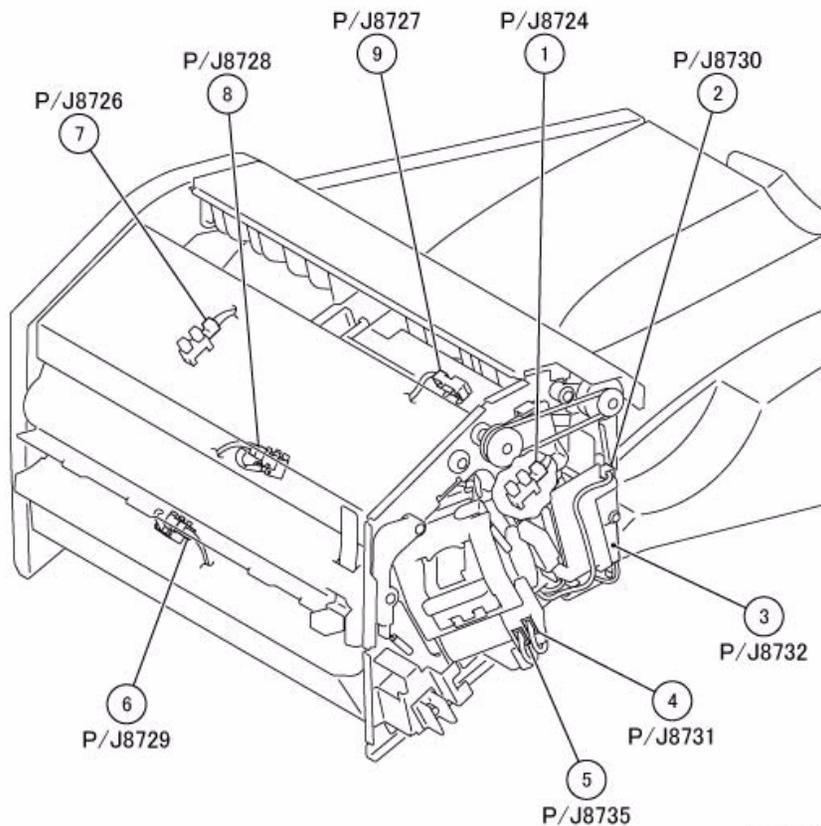
Figure 1 Integrated Office Finisher Front Location

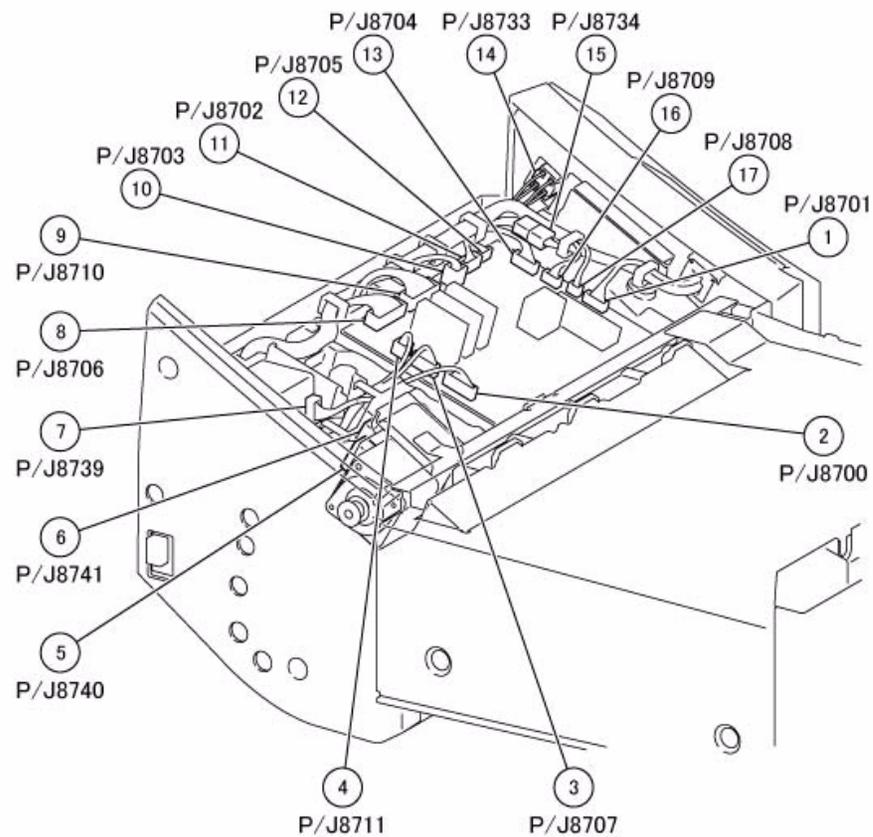
Figure 2 Integrated Office Finisher PWB Location

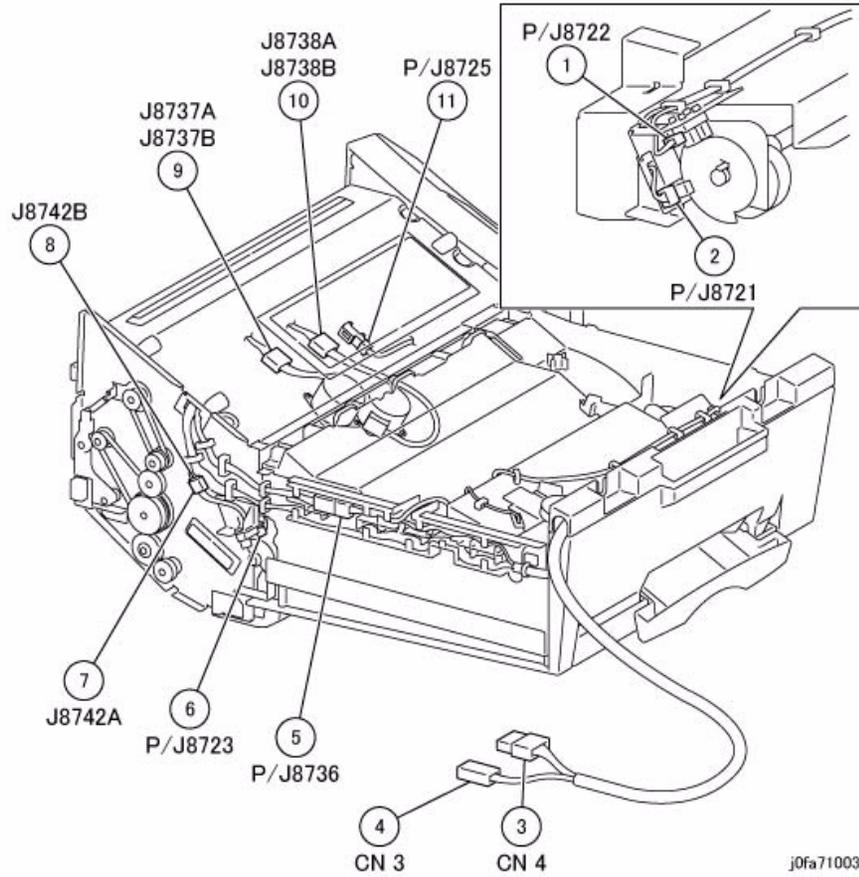
Figure 3 Integrated Office Finisher Bottom Location

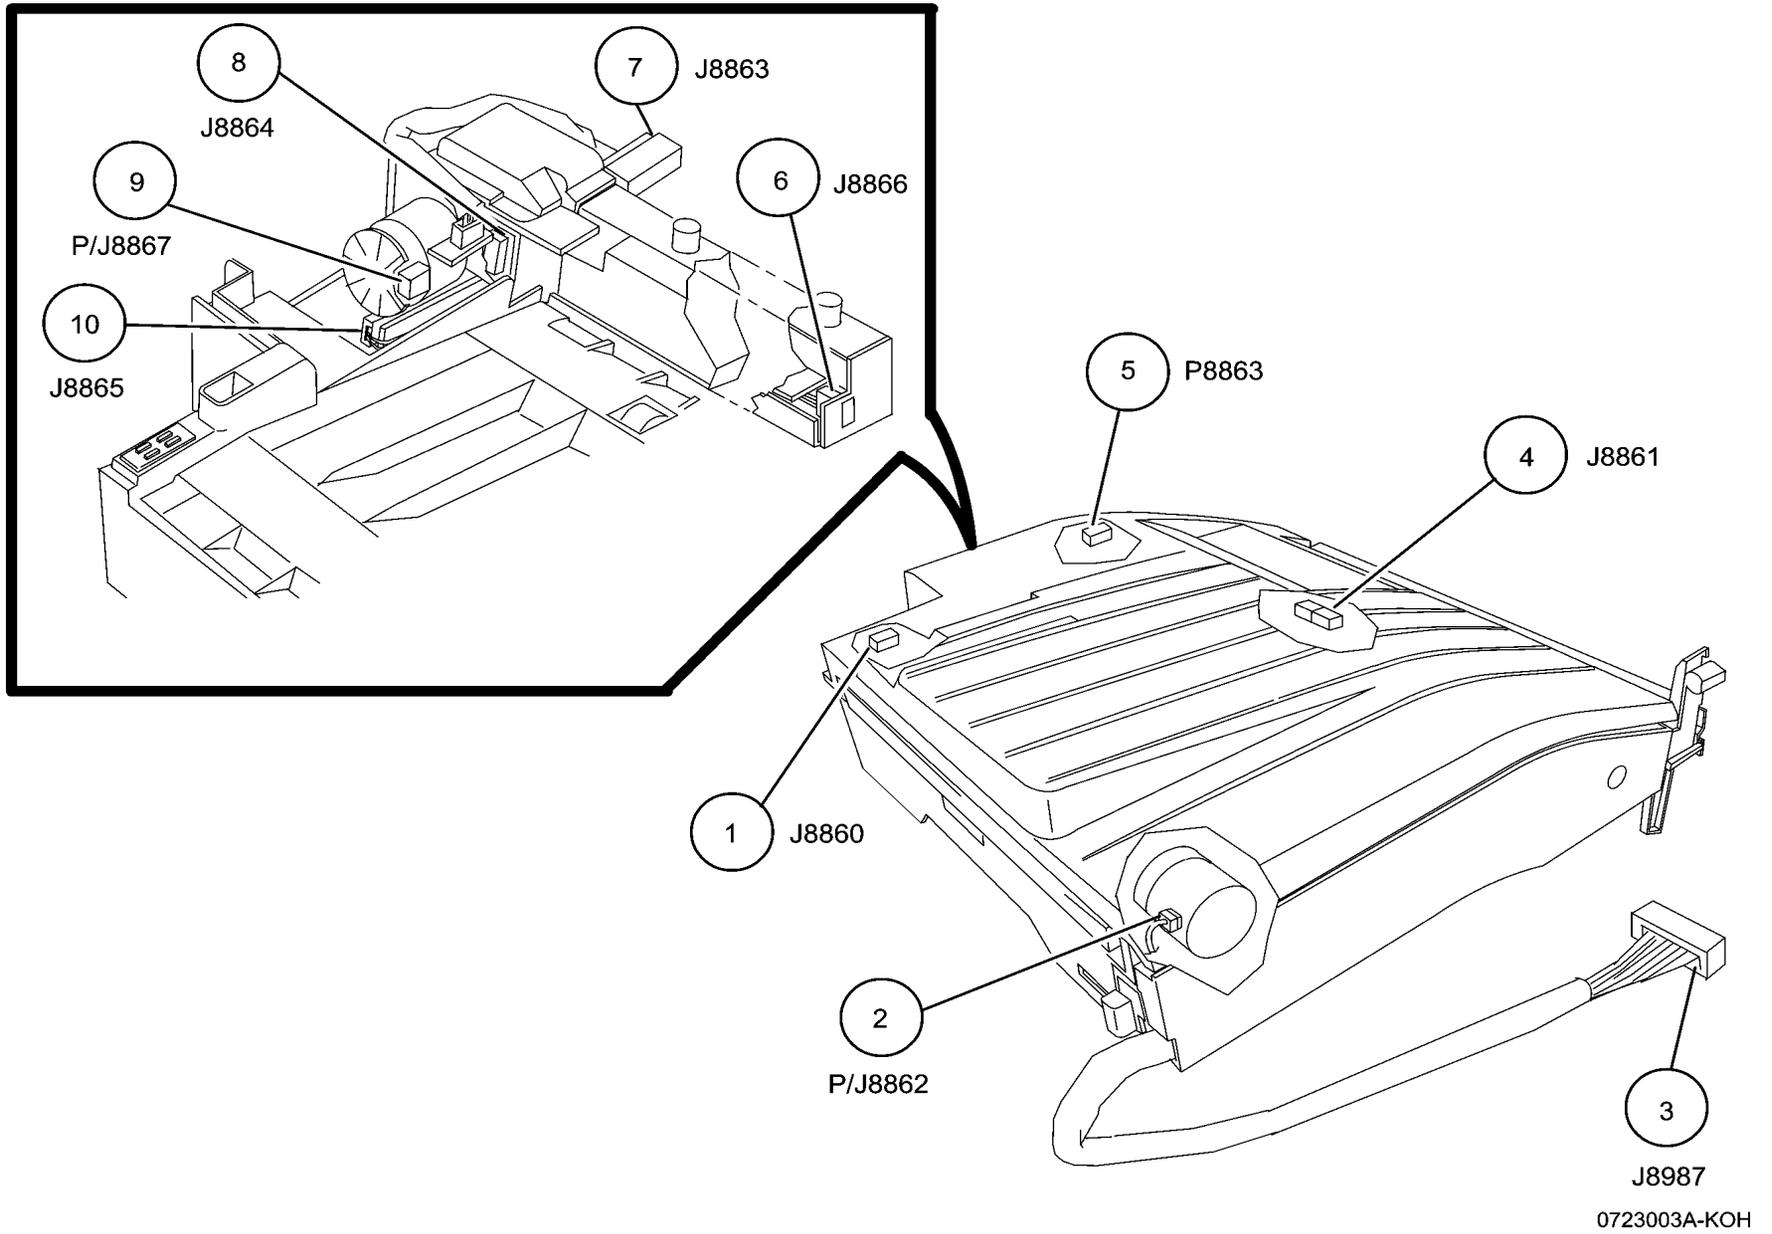
Figure 1 Finisher (LX) Horizontal Transport

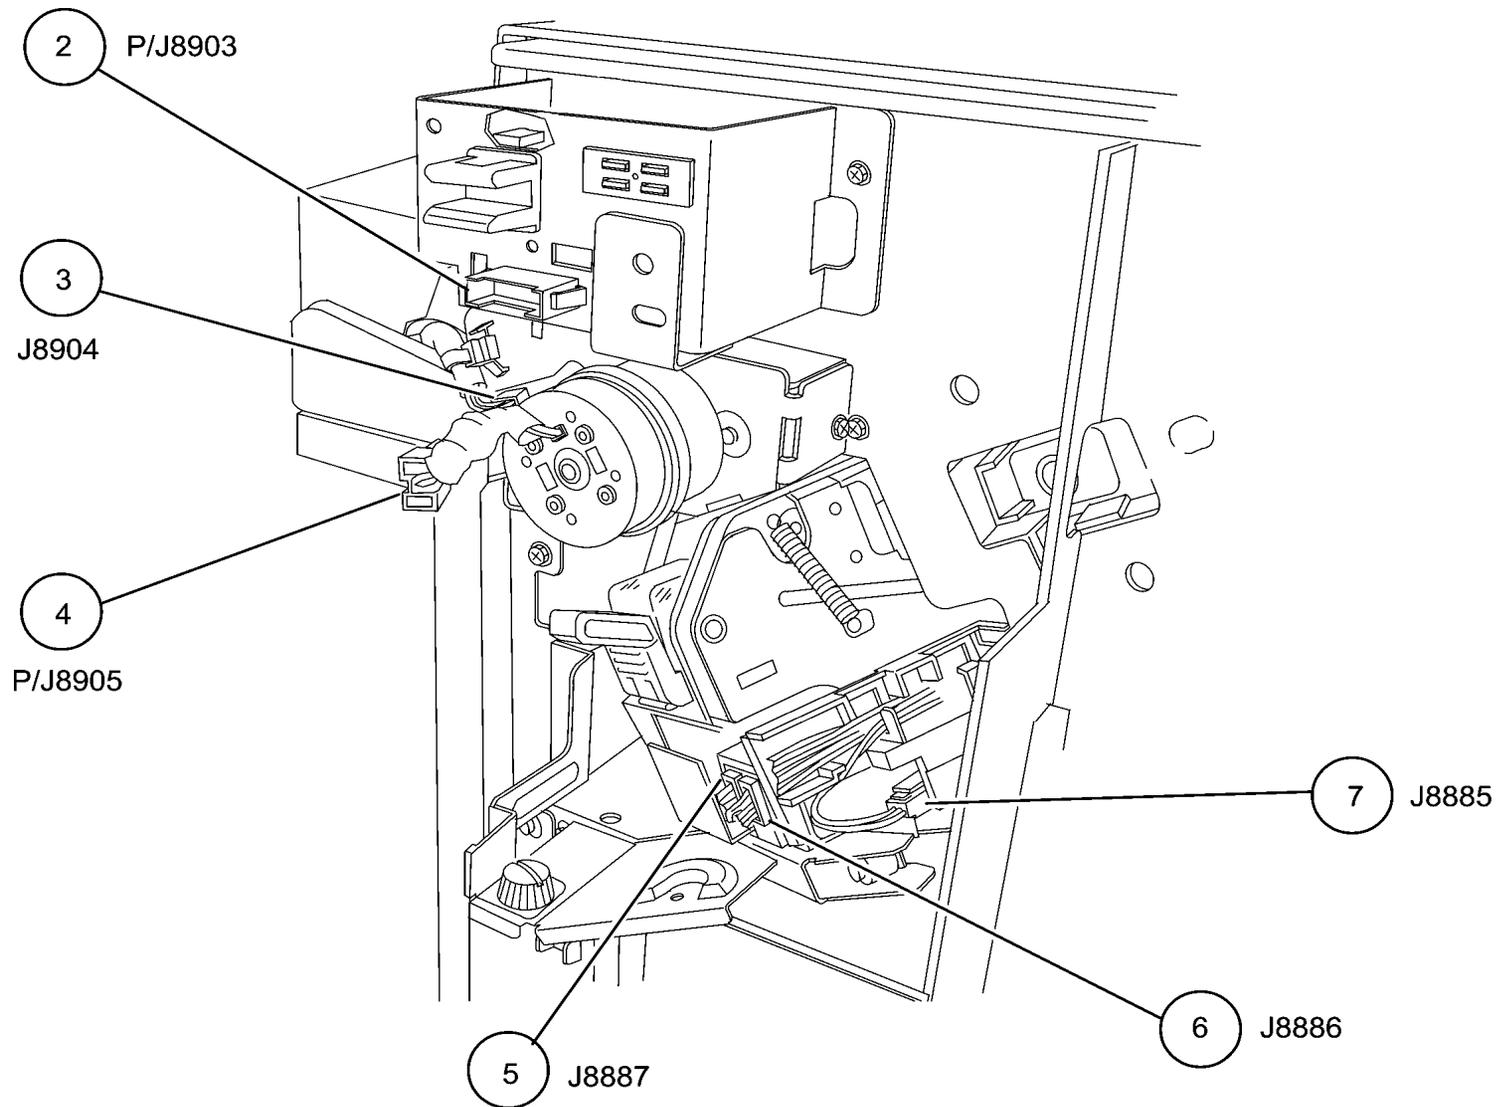
Figure 2 Finisher (LX) Front

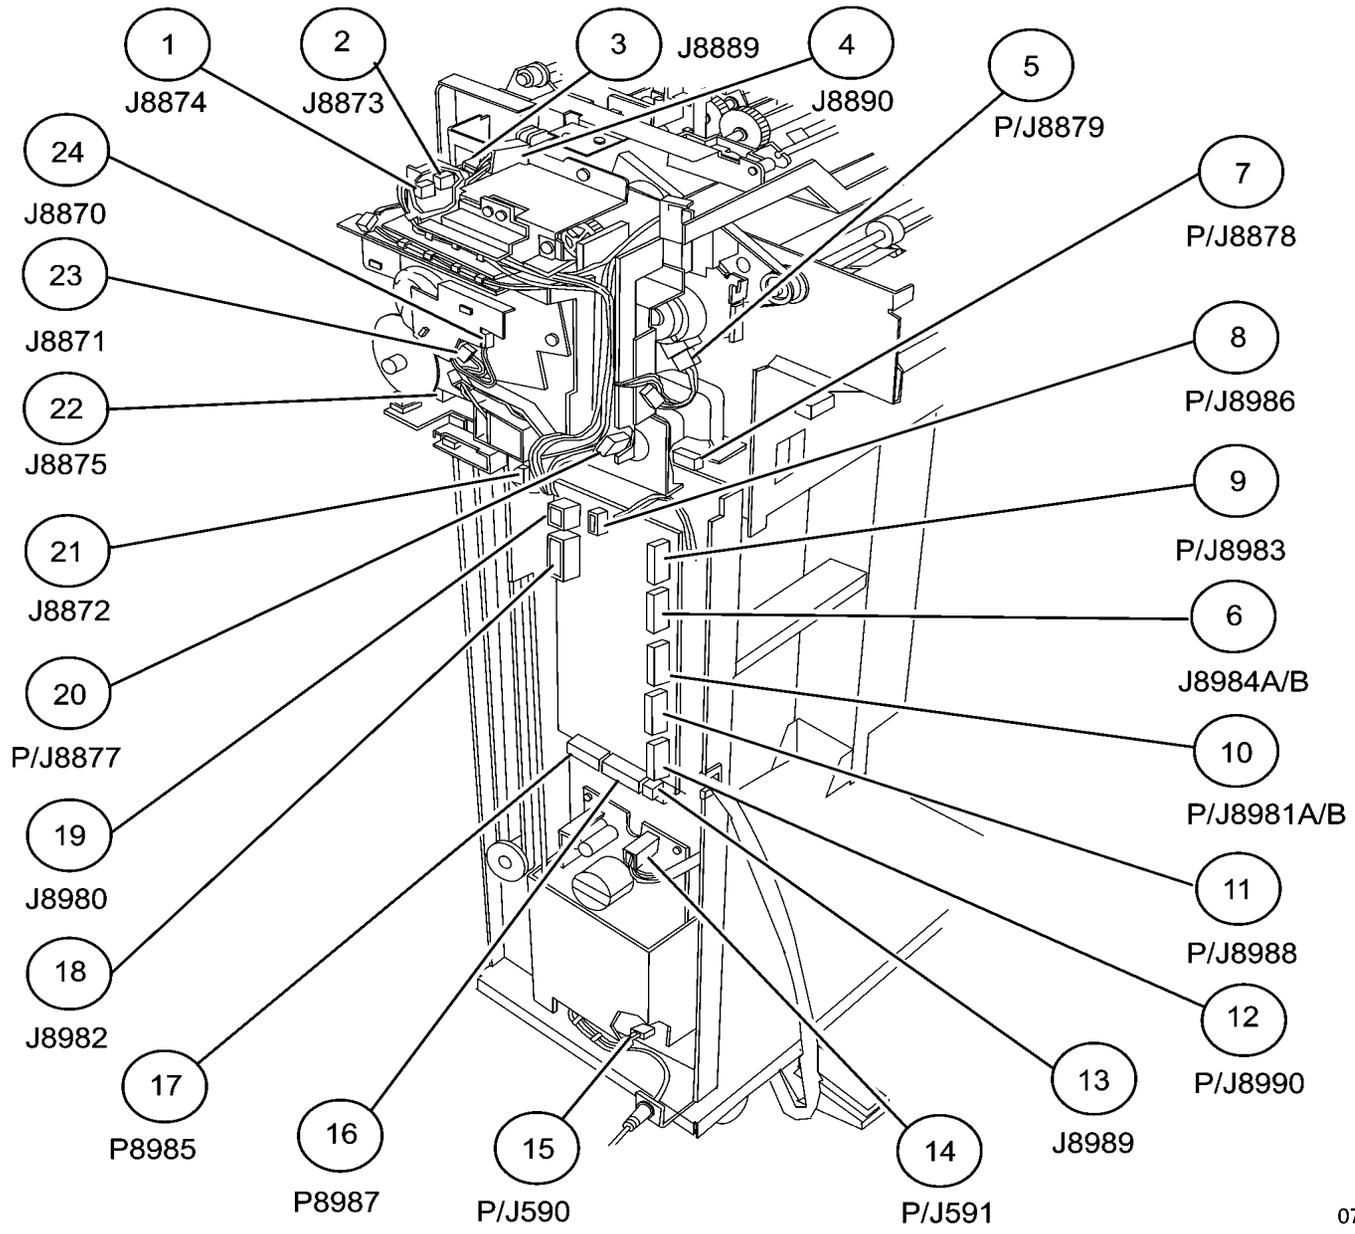
Figure 3 Finisher (LX) Rear

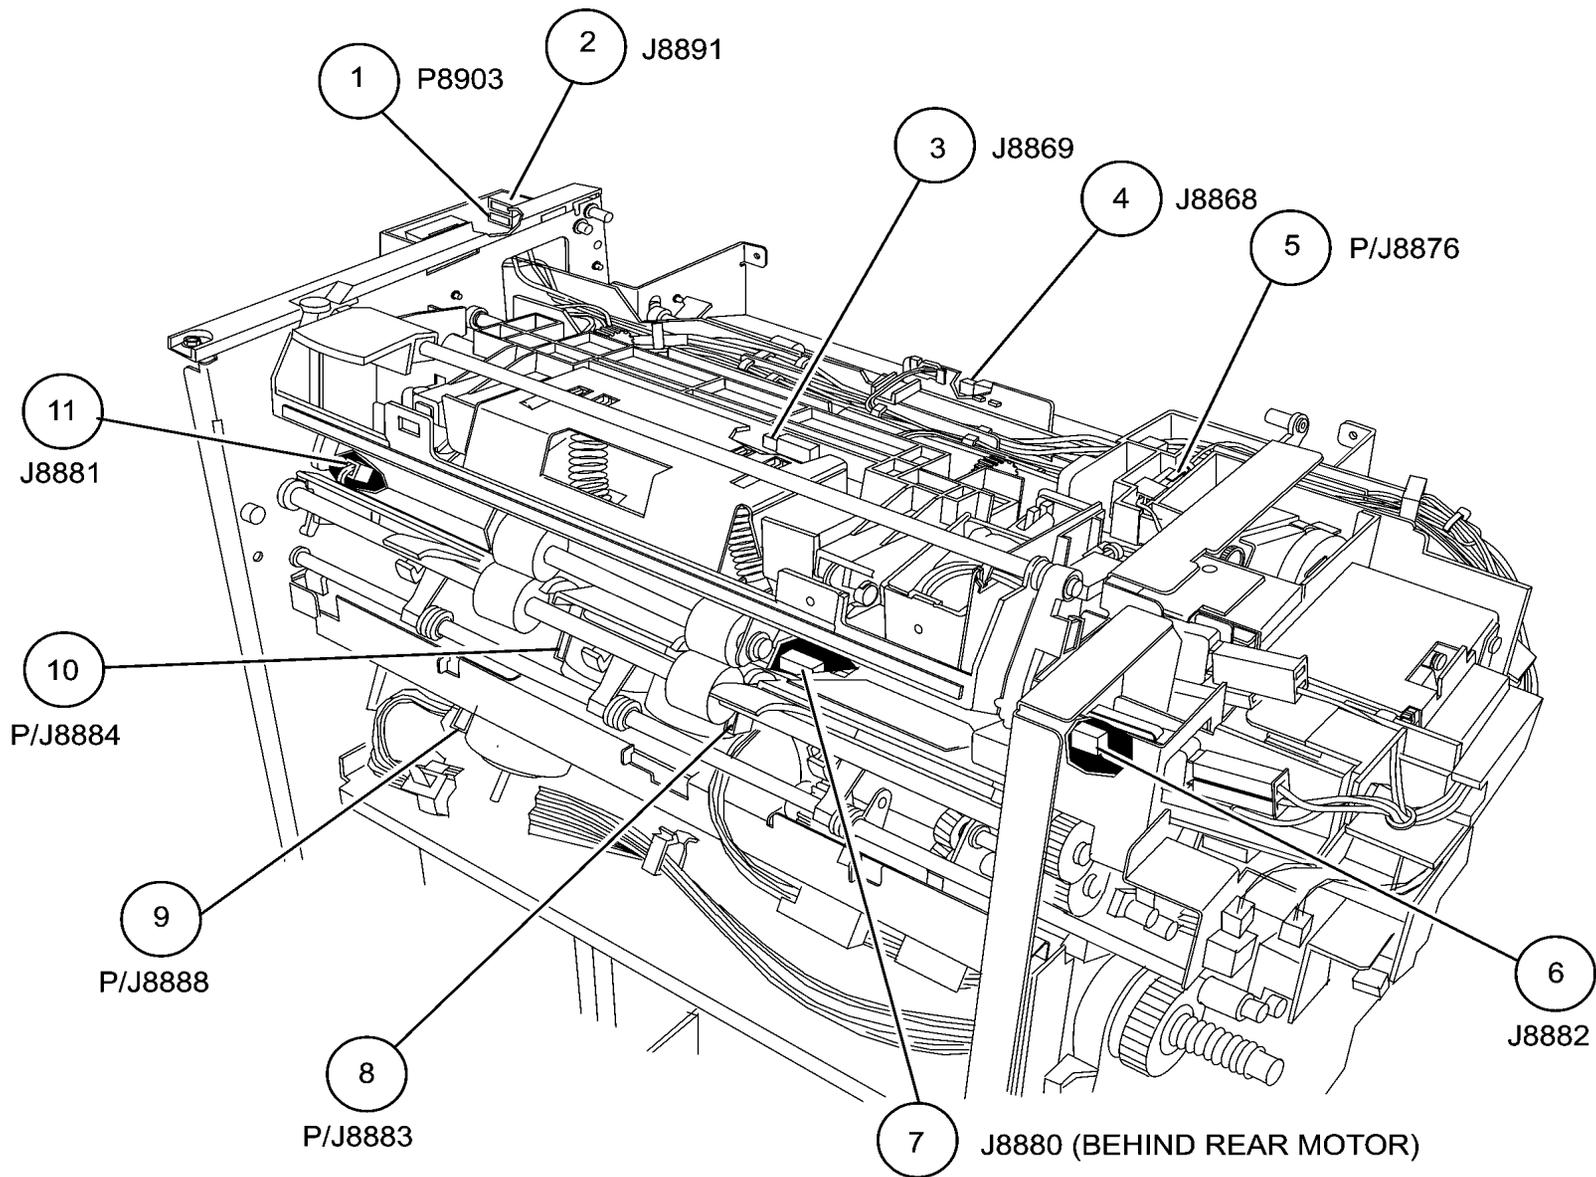
Figure 4 Finisher (LX) Eject

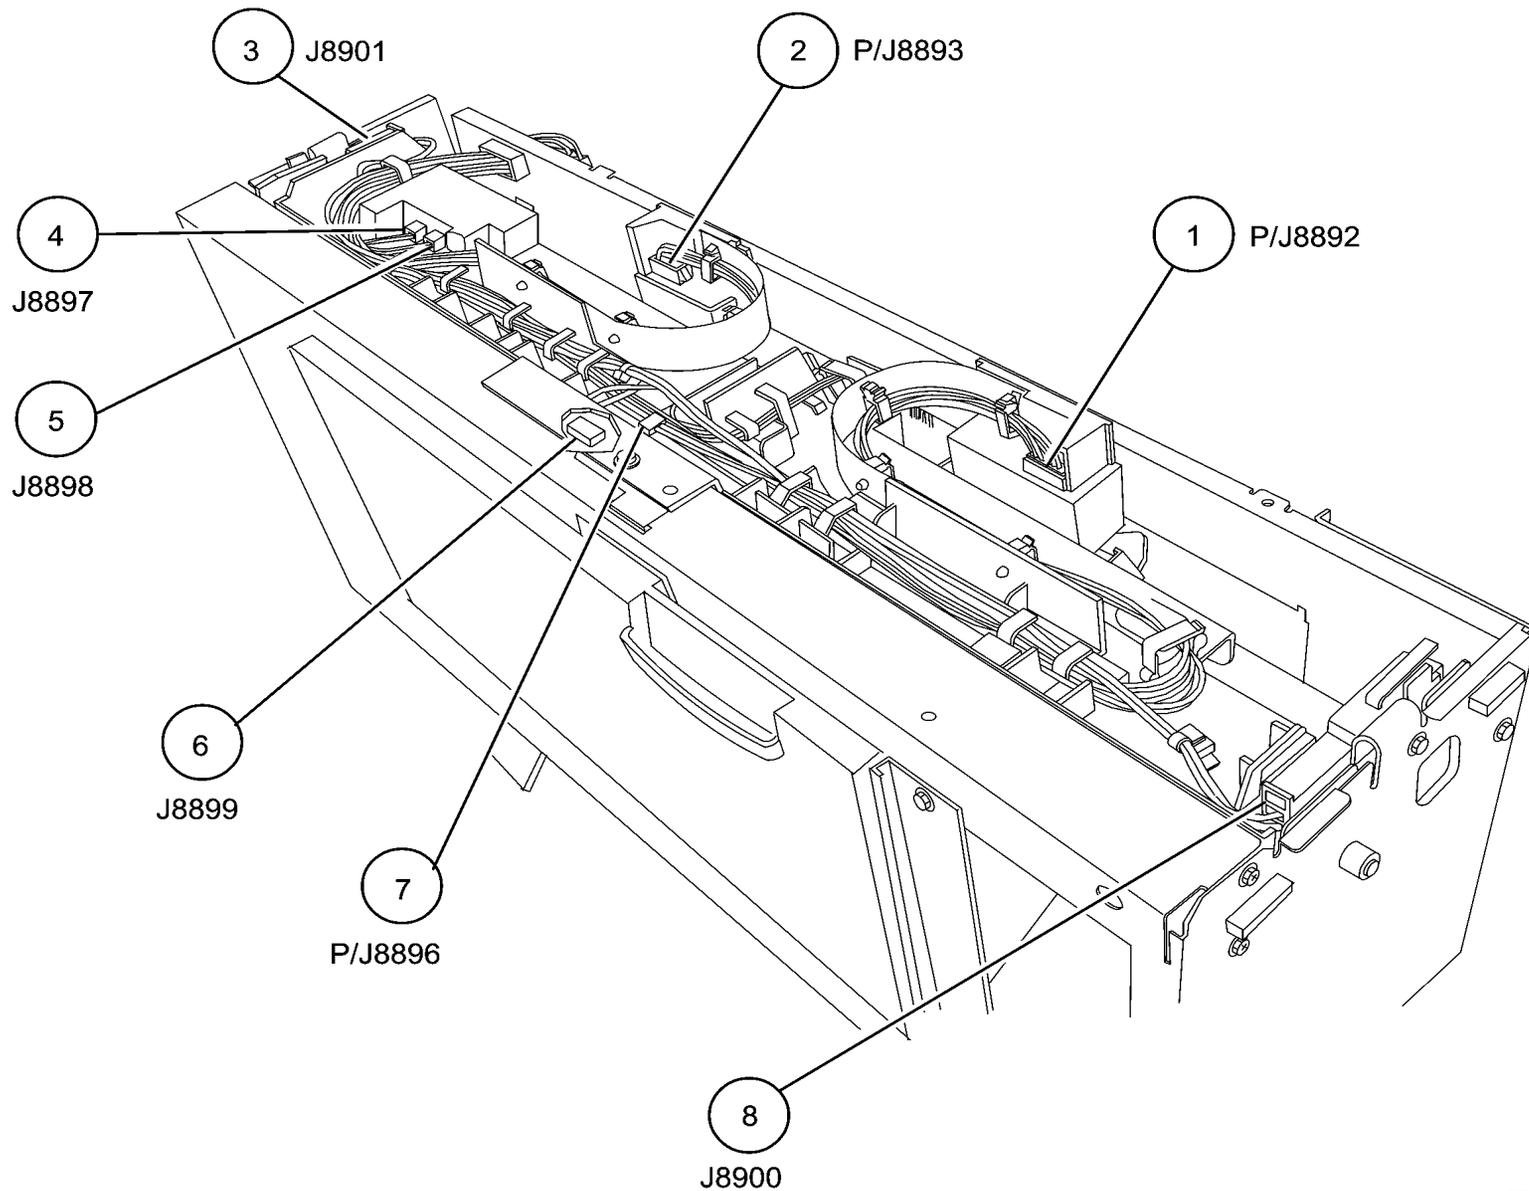
Figure 5 Booklet Maker Stapler Assembly

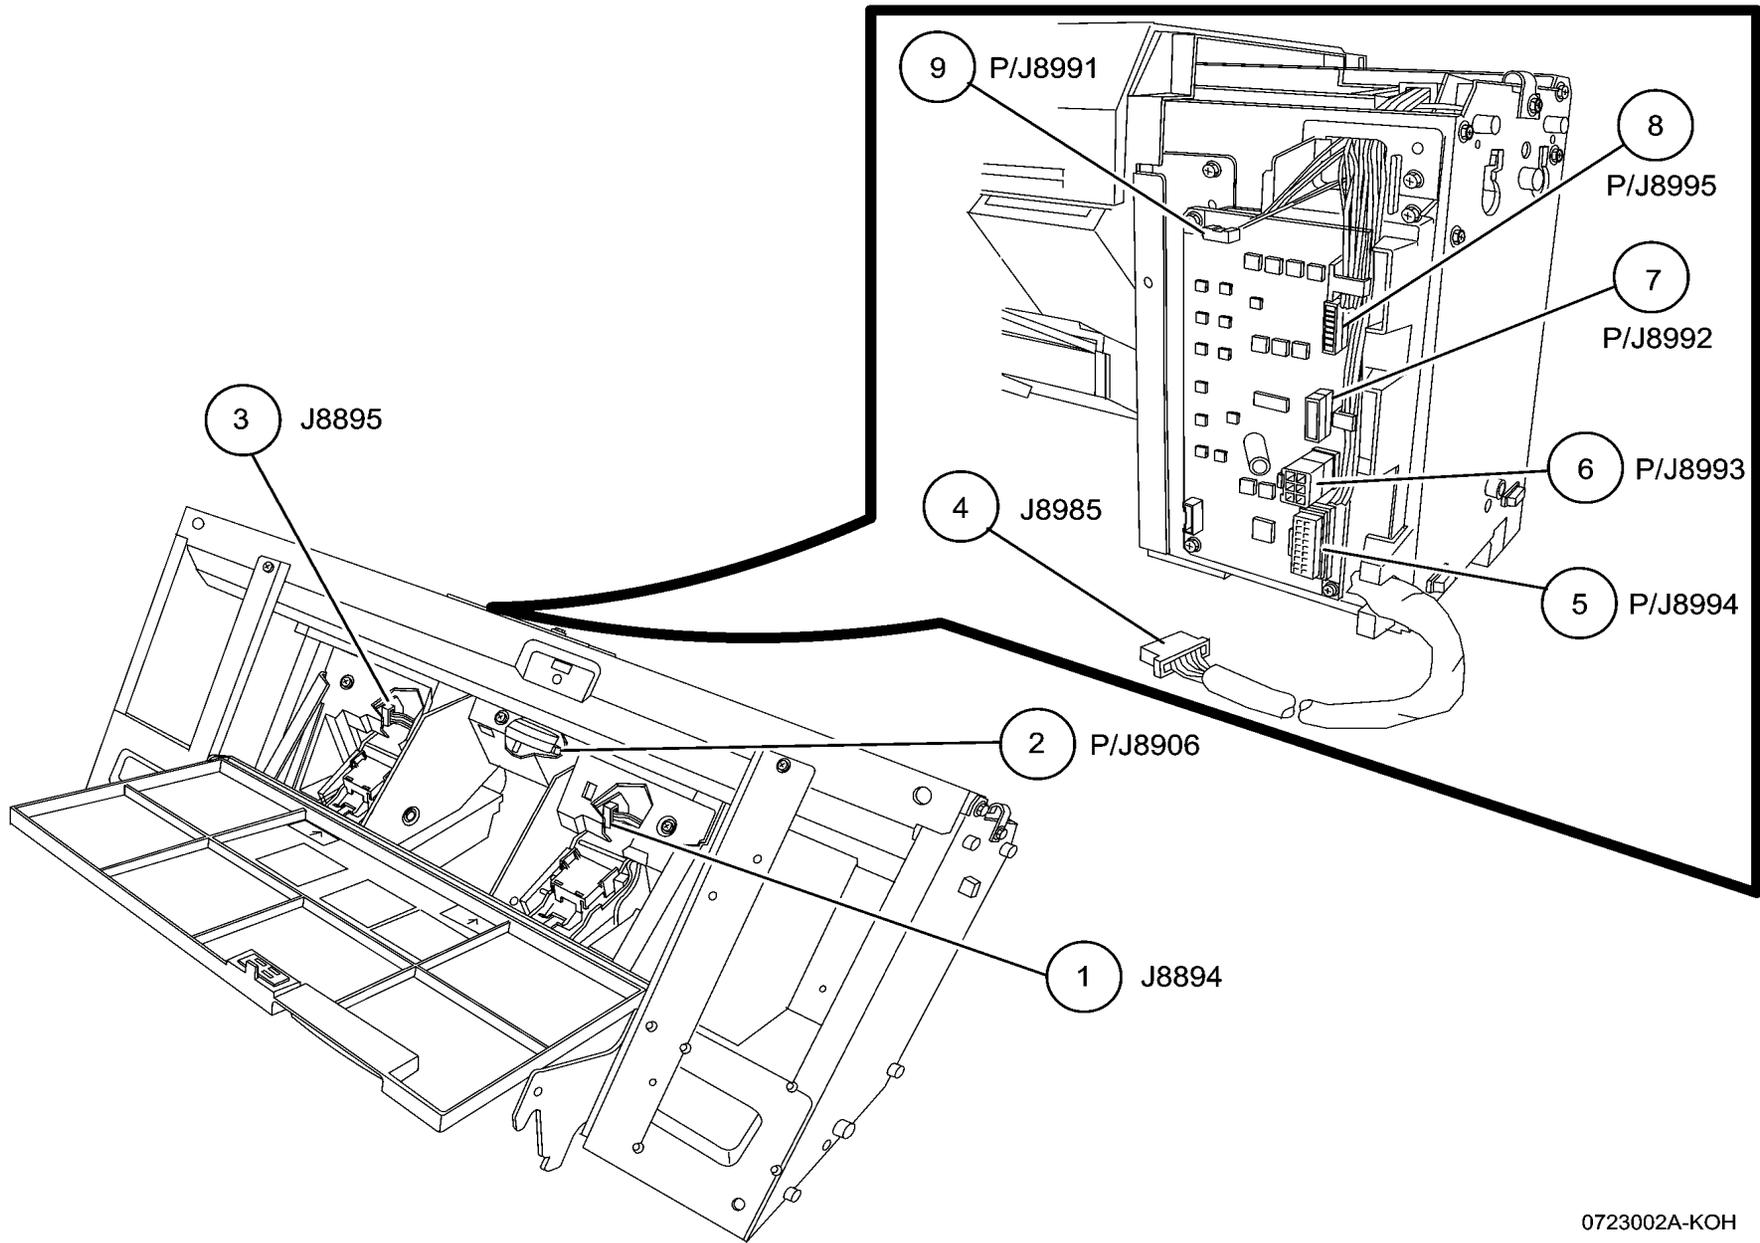
Figure 6 Booklet Maker PWB

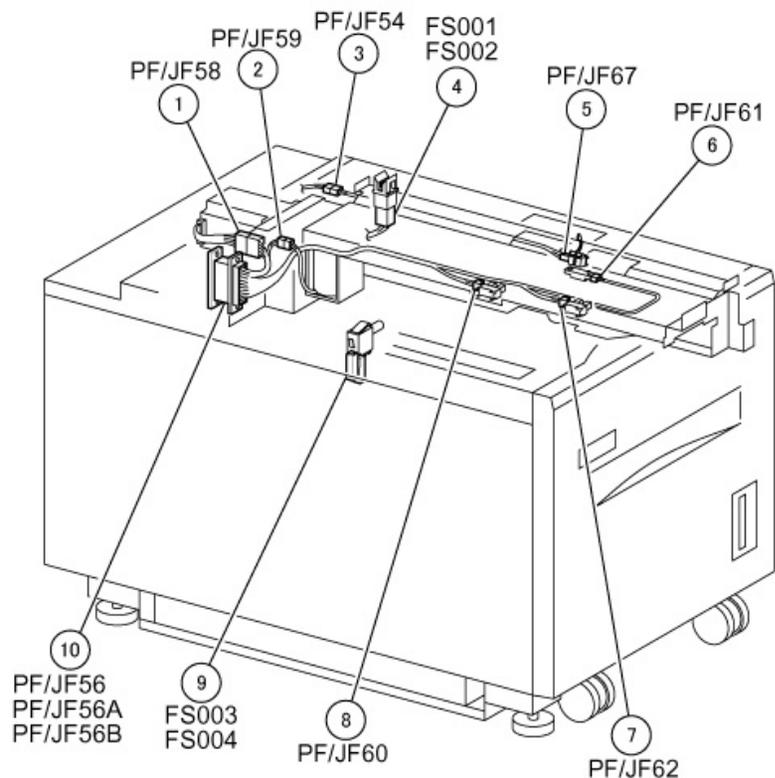
Figure 1 HCF 1/2

Connector Number	Figure Number	Item Number	Remarks
FS004	Figure 1	9	HCF Docking Interlock Switch
PF/JF01	Figure 2	4	HCF PWB
PF/JF02	Figure 2	5	HCF PWB
PF/JF03	Figure 2	6	HCF PWB
PF/JF04	Figure 2	7	HCF PWB
PF/JF05	Figure 2	8	HCF PWB
PF/JF06	Figure 2	9	HCF PWB
PF/JF08	Figure 2	3	HCF PWB
PF/JF51	Figure 2	2	HCF (Tray 6 Size Sensor (Letter))
PF/JF52	Figure 2	1	HCF (Tray 6 Size Sensor (A4))
PF/JF53	Figure 2	10	HCF (Tray 6 In Sensor)
PF/JF54	Figure 1	3	HCF
PF/JF56	Figure 1	10	HCF
PF/JF56A	Figure 1	10	HCF
PF/JF56B	Figure 1	10	HCF
PF/JF57	Figure 2	11	HCF (Tray 6 Takeaway Motor)
PF/JF58	Figure 1	1	HCF (Tray 6 Lift Feed Motor)
PF/JF59	Figure 1	2	HCF
PF/JF60	Figure 1	8	HCF
PF/JF61	Figure 1	6	HCF (Tray 6 Pre Feed Sensor)
PF/JF62	Figure 1	7	HCF (Tray 6 Stack Height Sensor)
PF/JF67	Figure 1	5	HCF (Tray 6 Feed Out Sensor)

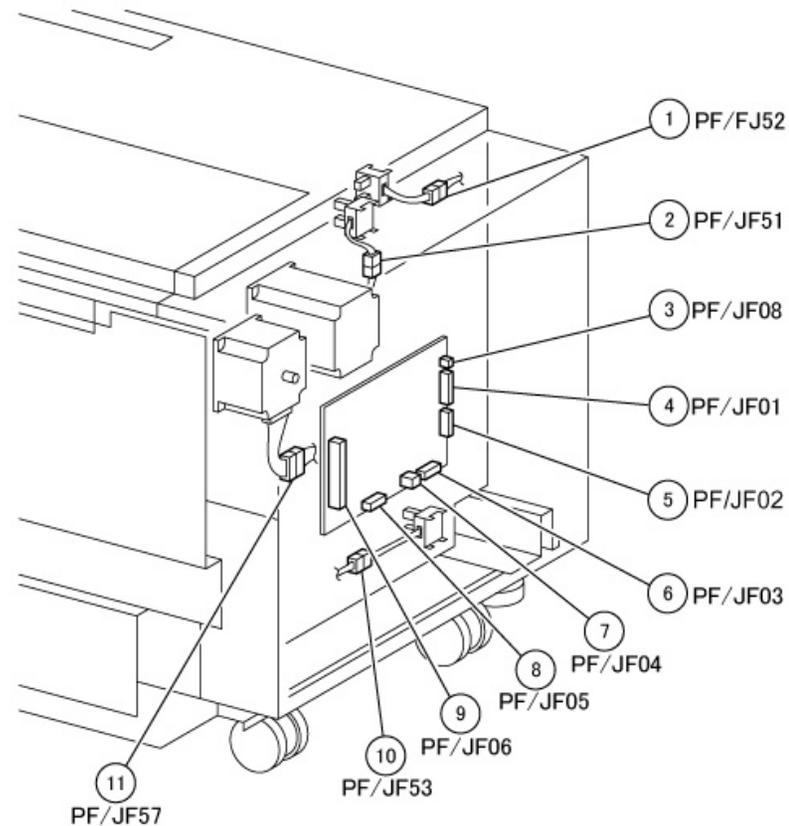
Figure 2 HCF 2/2
