WorkCentre 5335 Family Service Documentation

705P01303

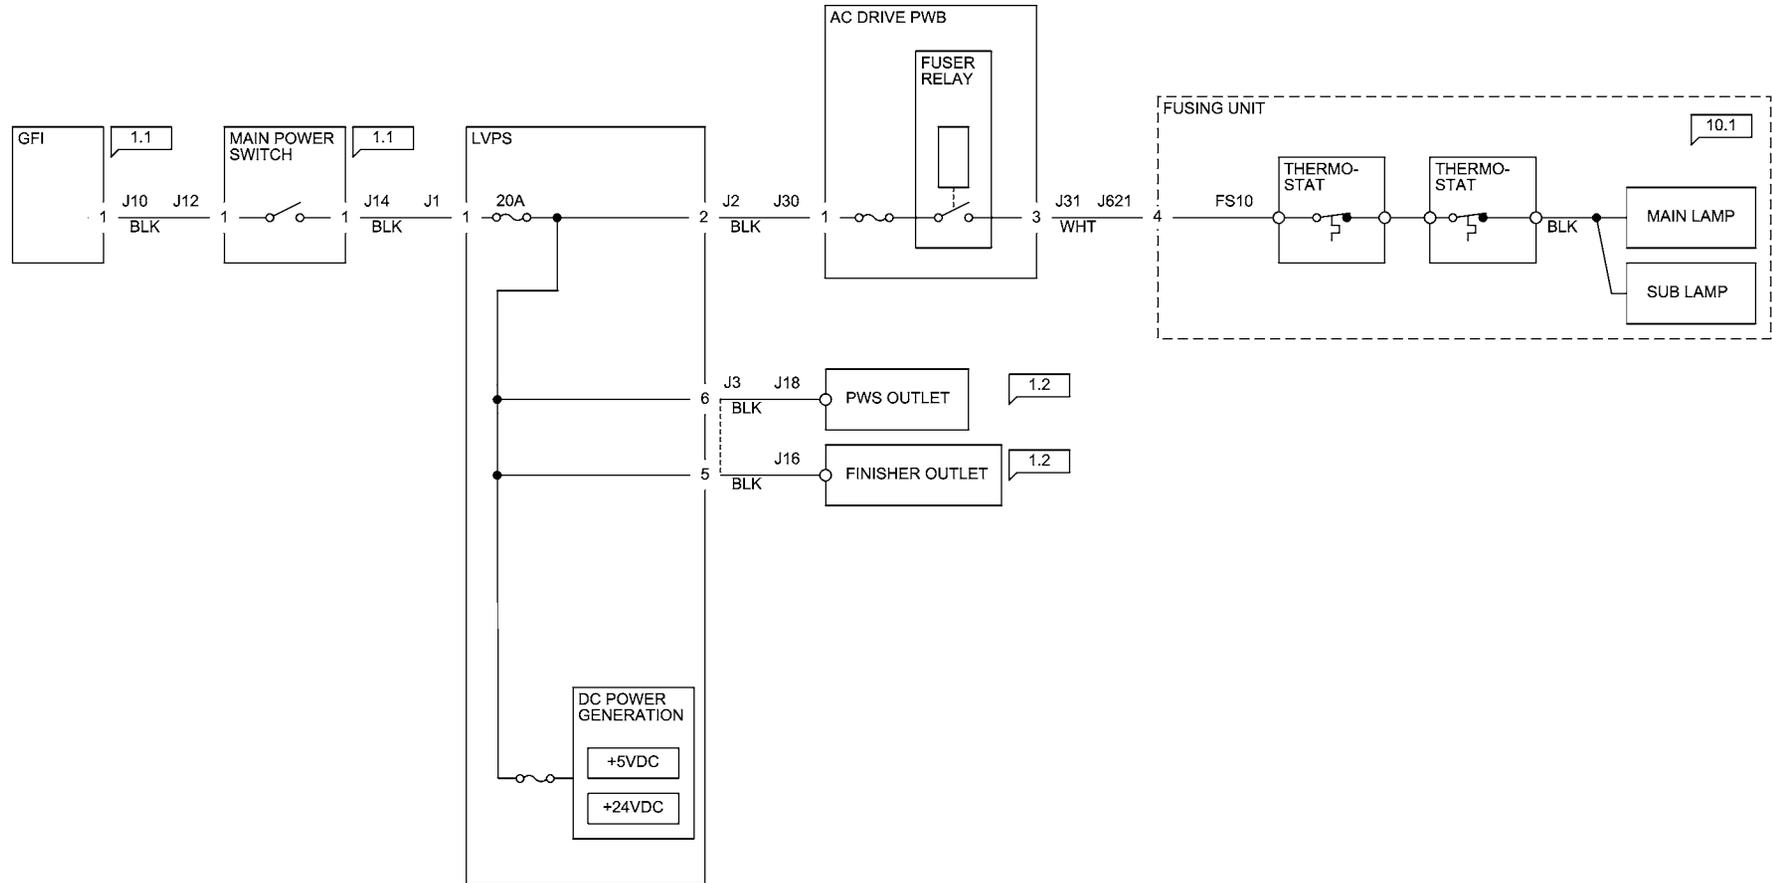
ACH WIRENET

Figure 1 ACH Wirenet

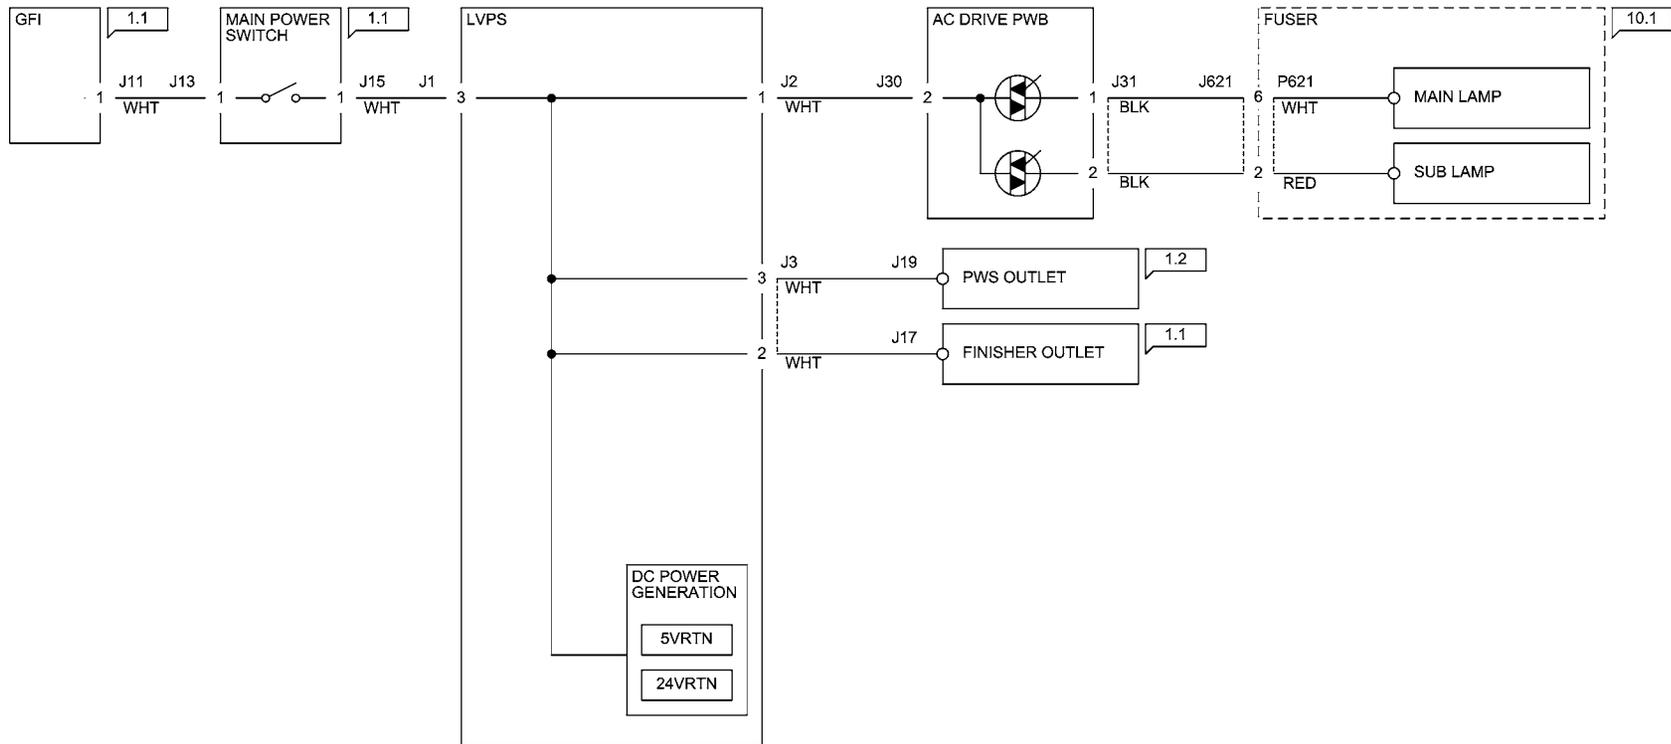
ACN WIRENET

Figure 2 ACN Wirenet

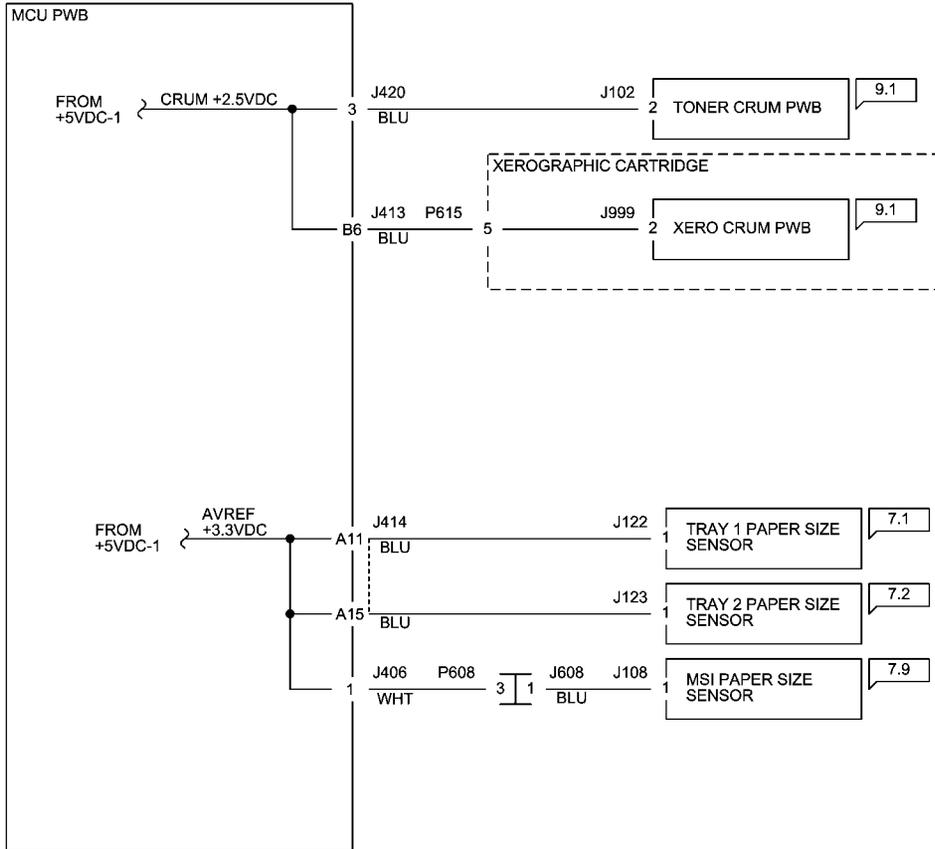
+2.5 VDC, AVREF 3.3 VDC WIRENETS

Figure 3 +2.5VDC/3.3VDC Wirenets

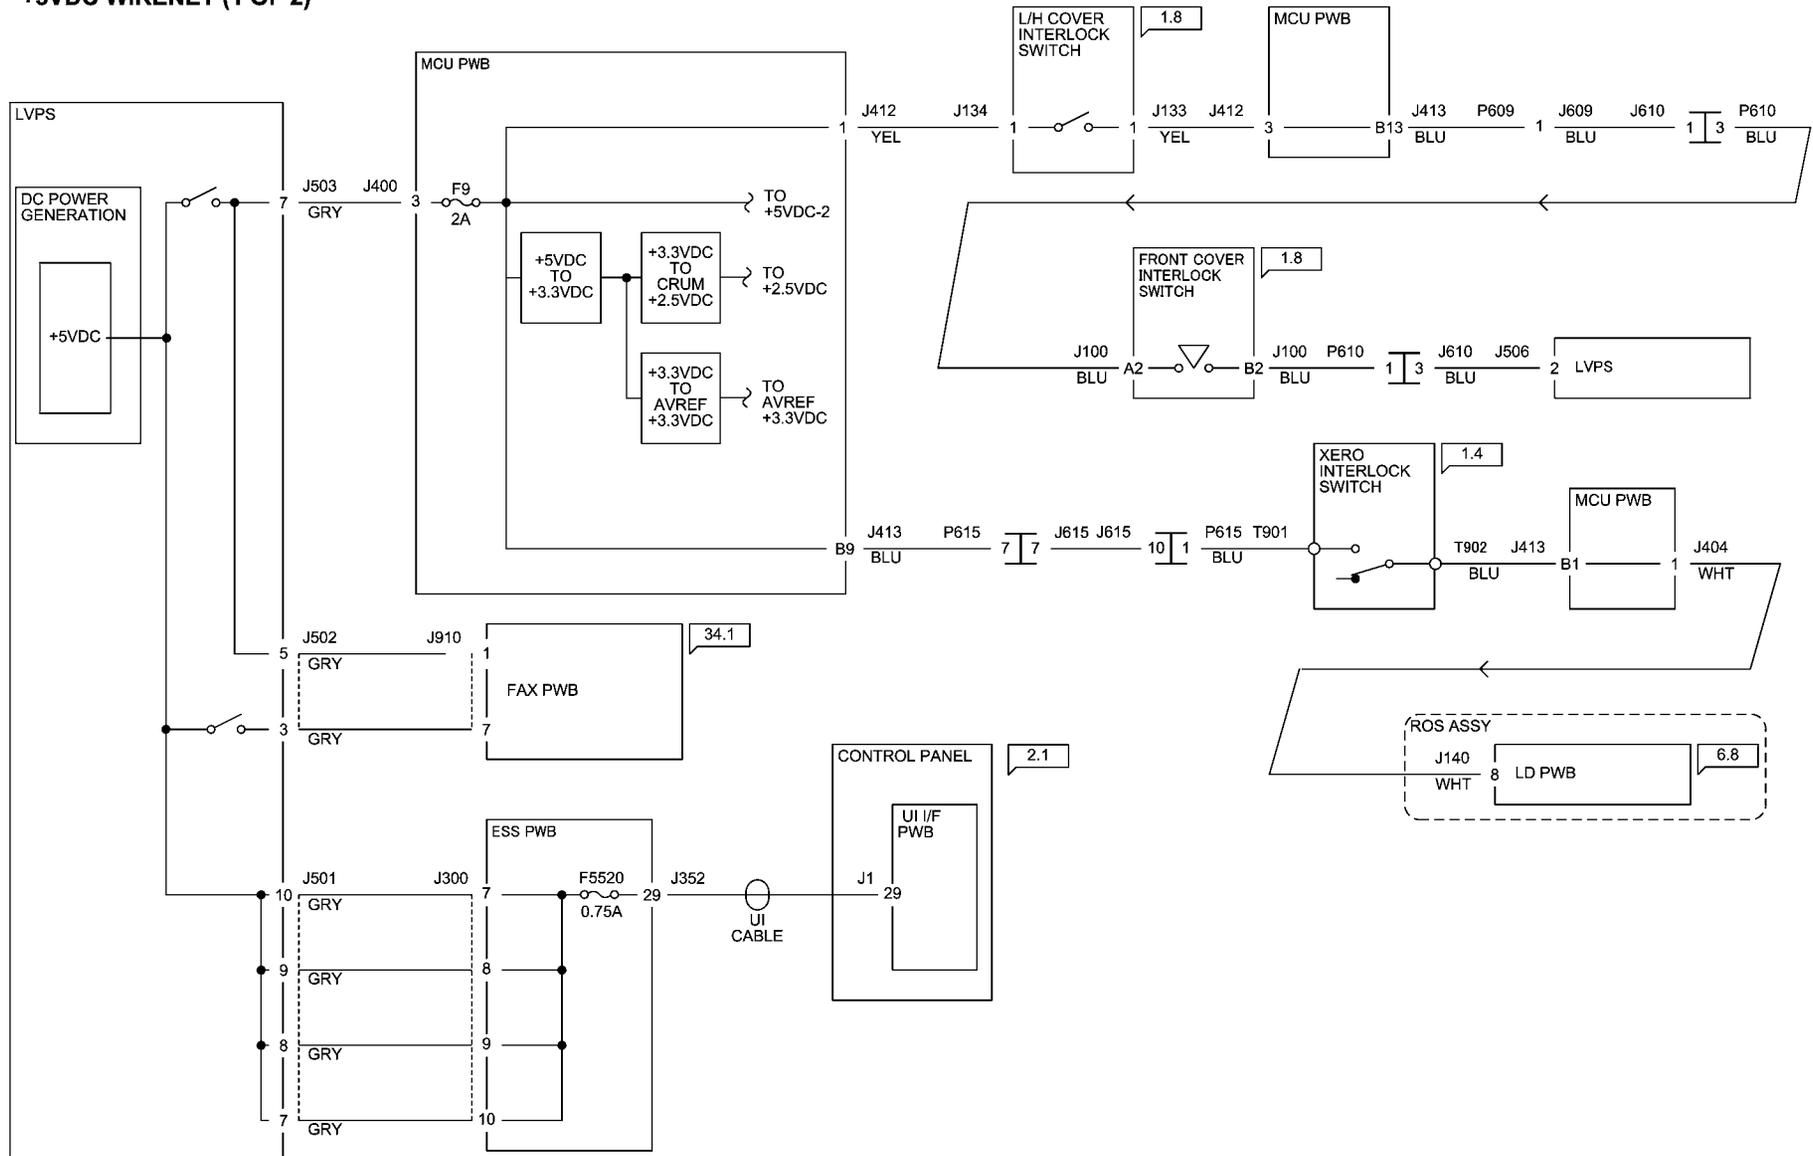
+5VDC WIRENET (1 OF 2)

Figure 4 +5VDC Wirenet (1 of 2)

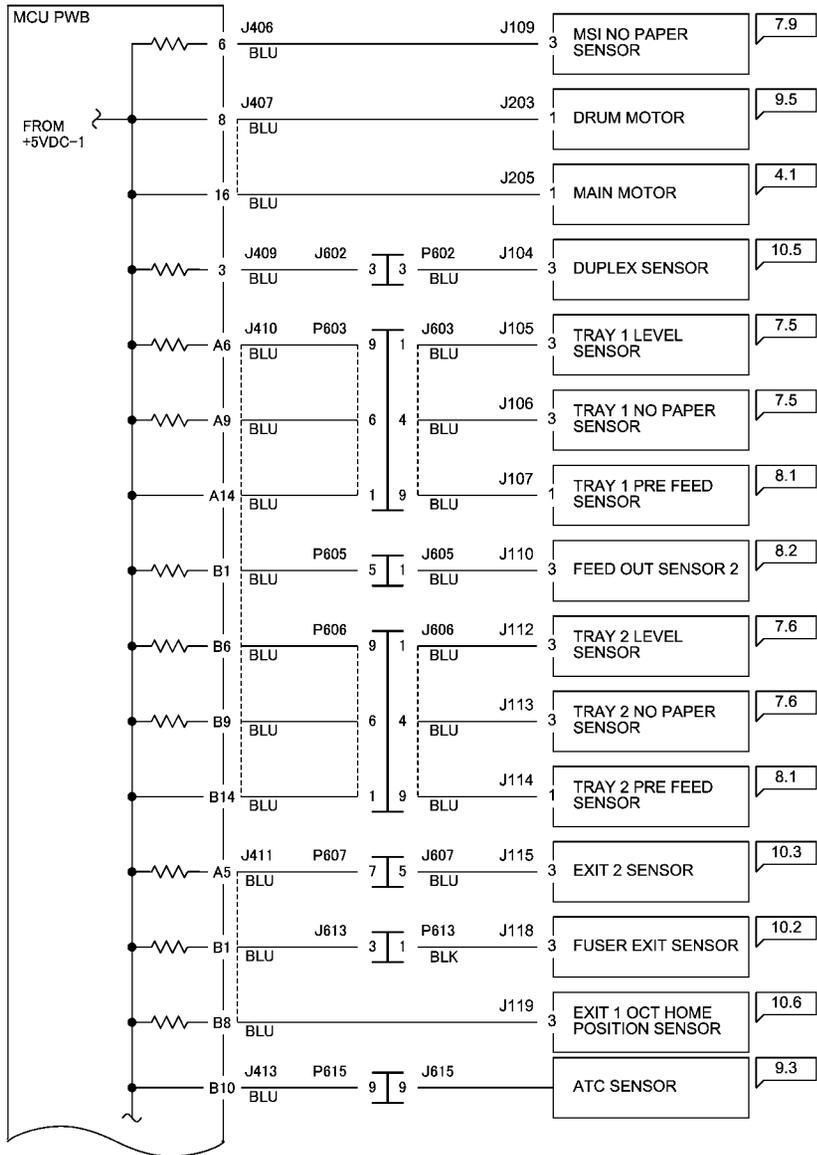
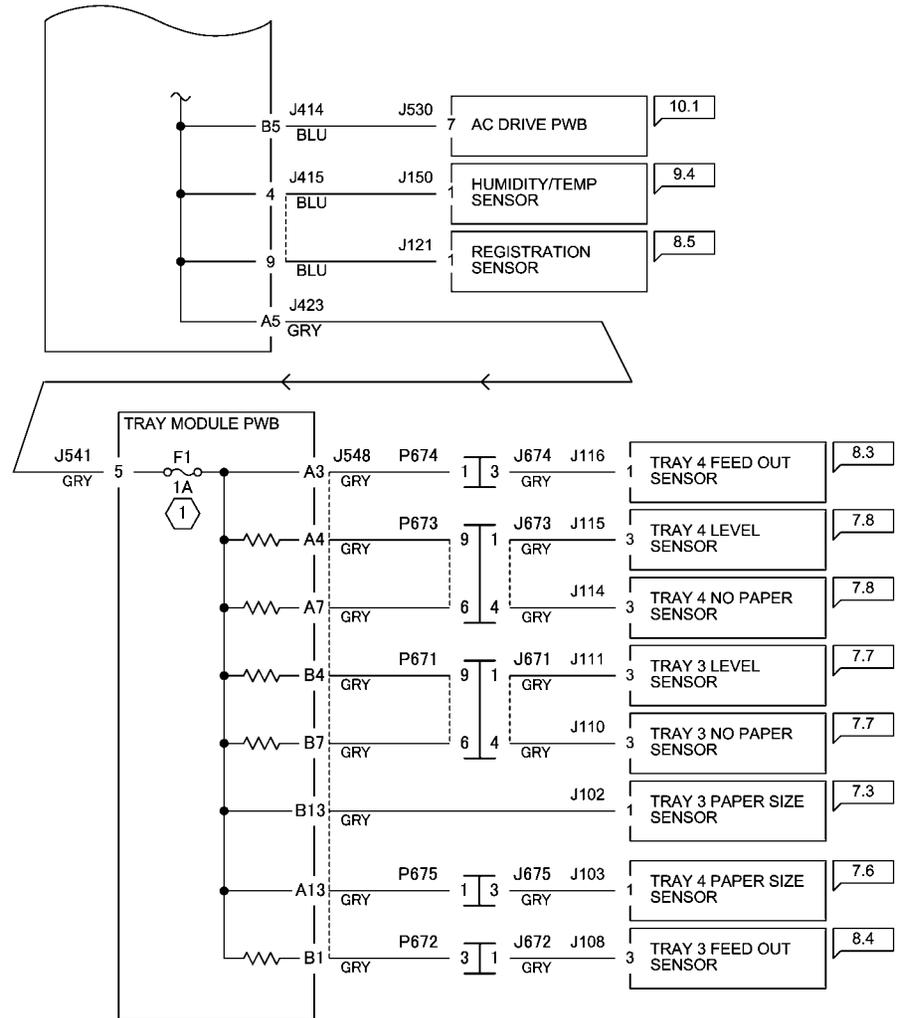
Figure 5 +5VDC Wirenet (2 of 2)

+5VDC WIRENET 2 OF 2

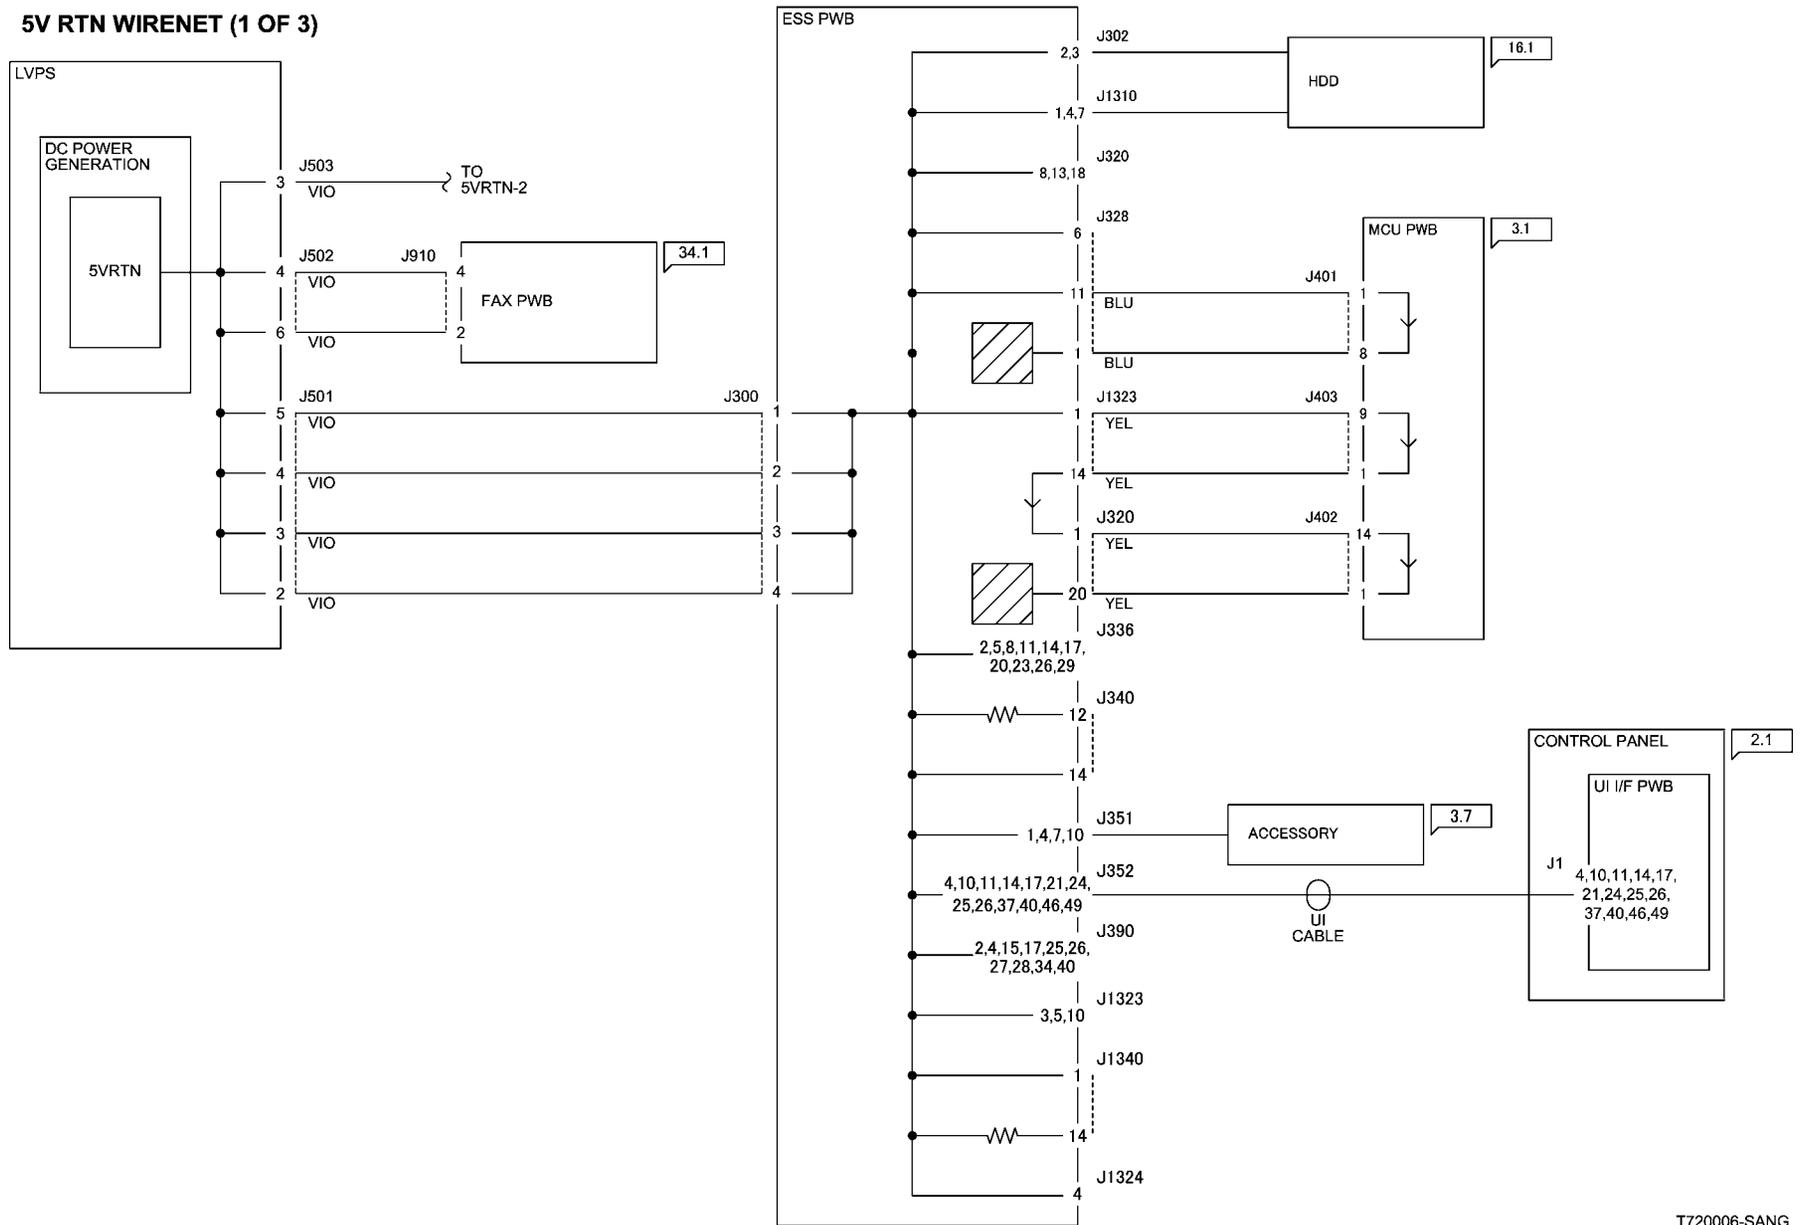
Figure 6 5V RTN Wirenet (1 of 3)

5V RTN WIRENET (1 OF 3)

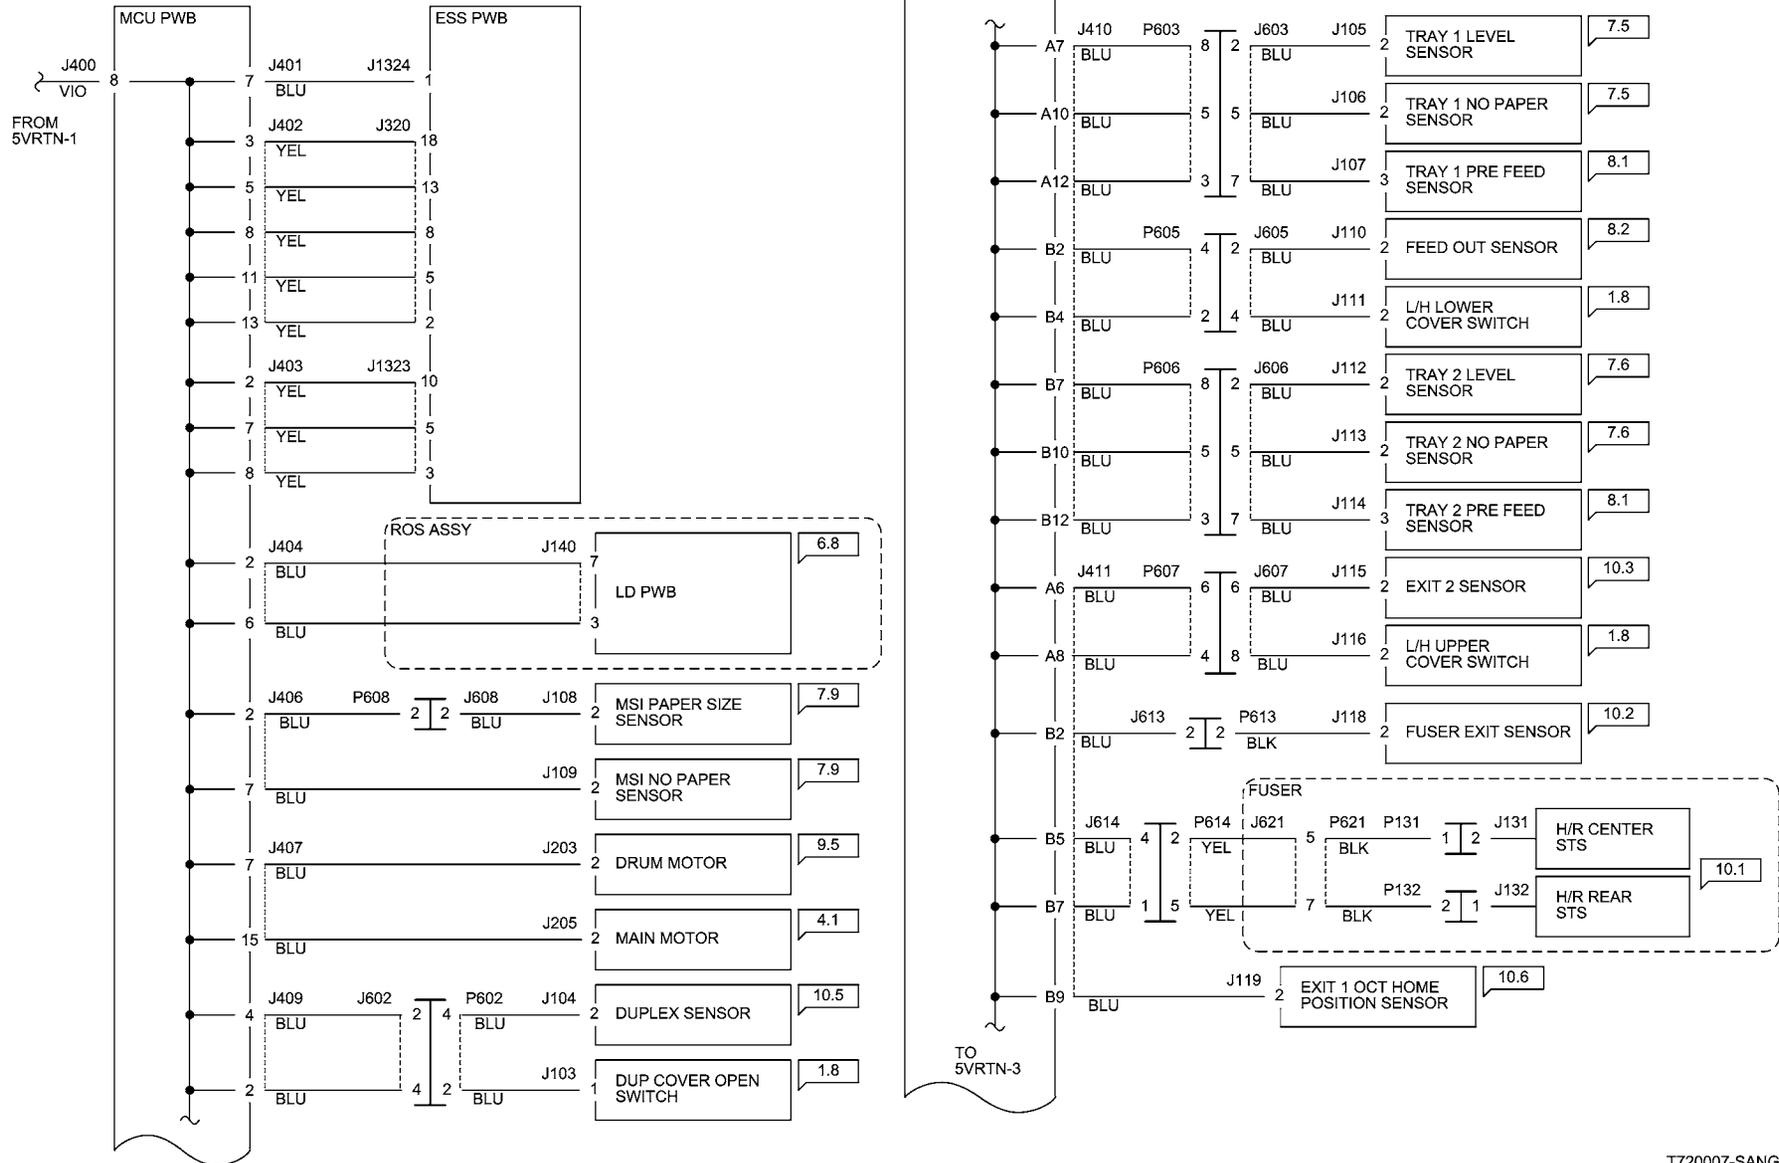
Figure 7 5V RTN Wirenet (2 of 3)

5V RTN WIRENET (2 OF 3)

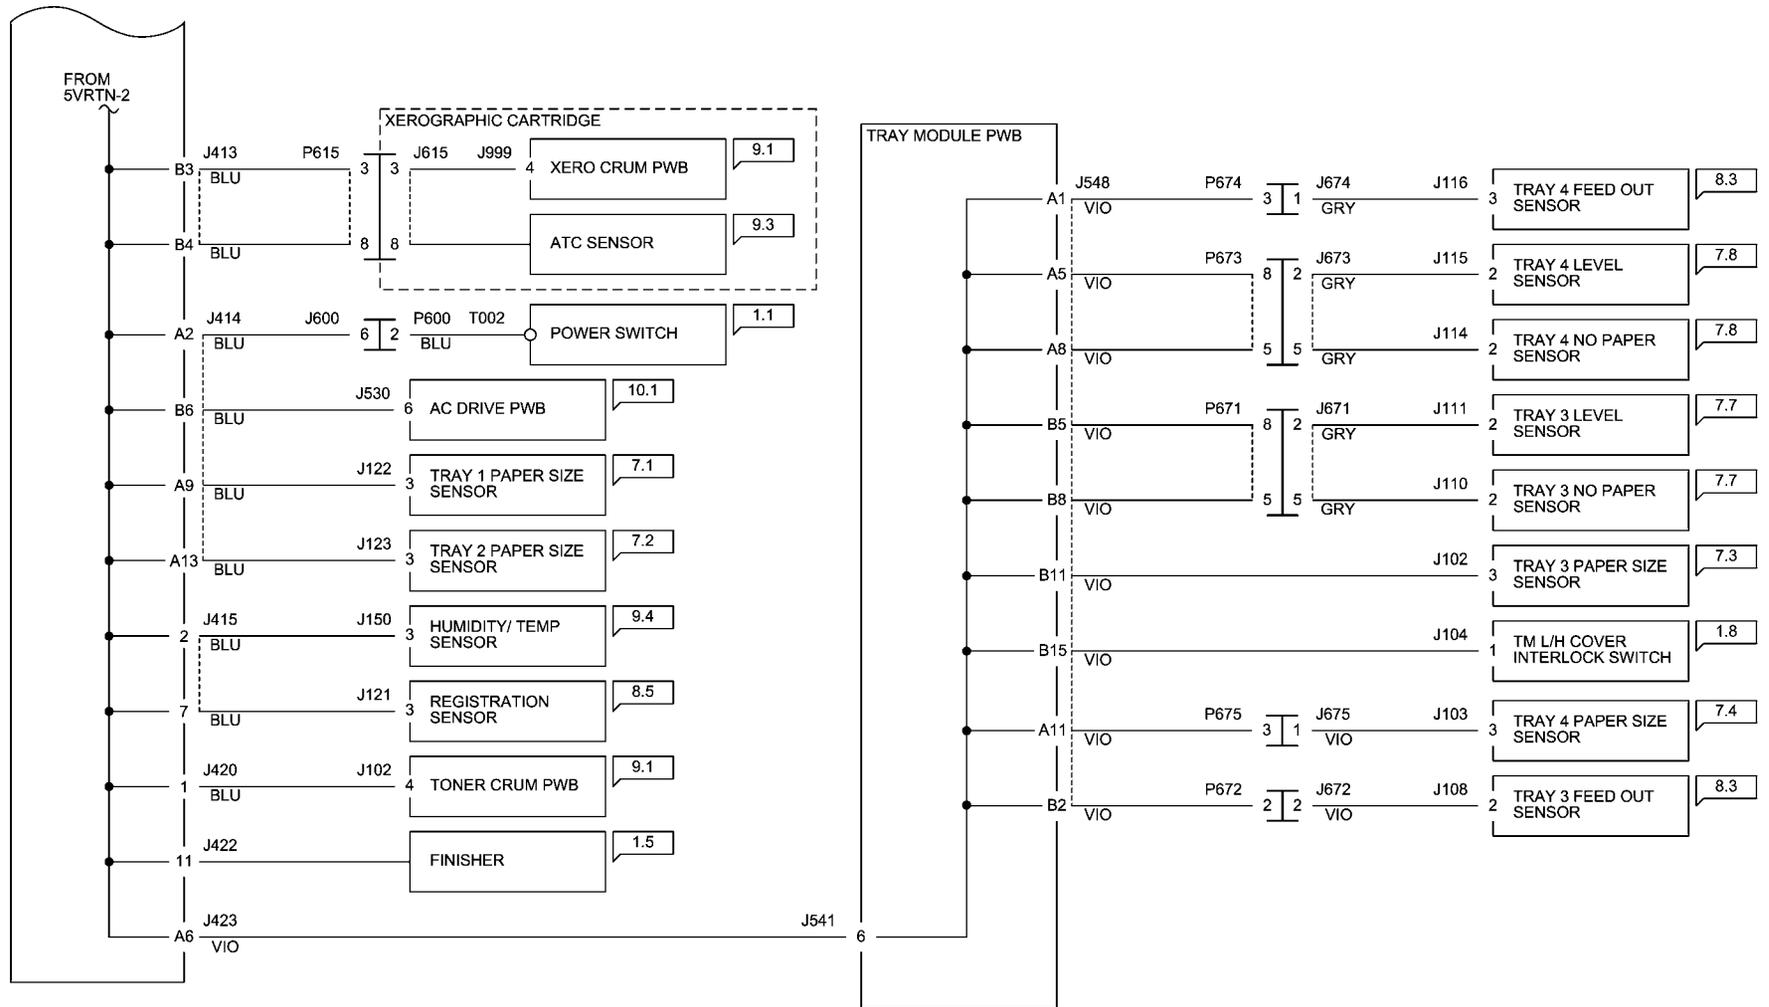
Figure 8 5V RTN Wirenet (3 of 3)

5V RTN WIRENET (3 OF 3)

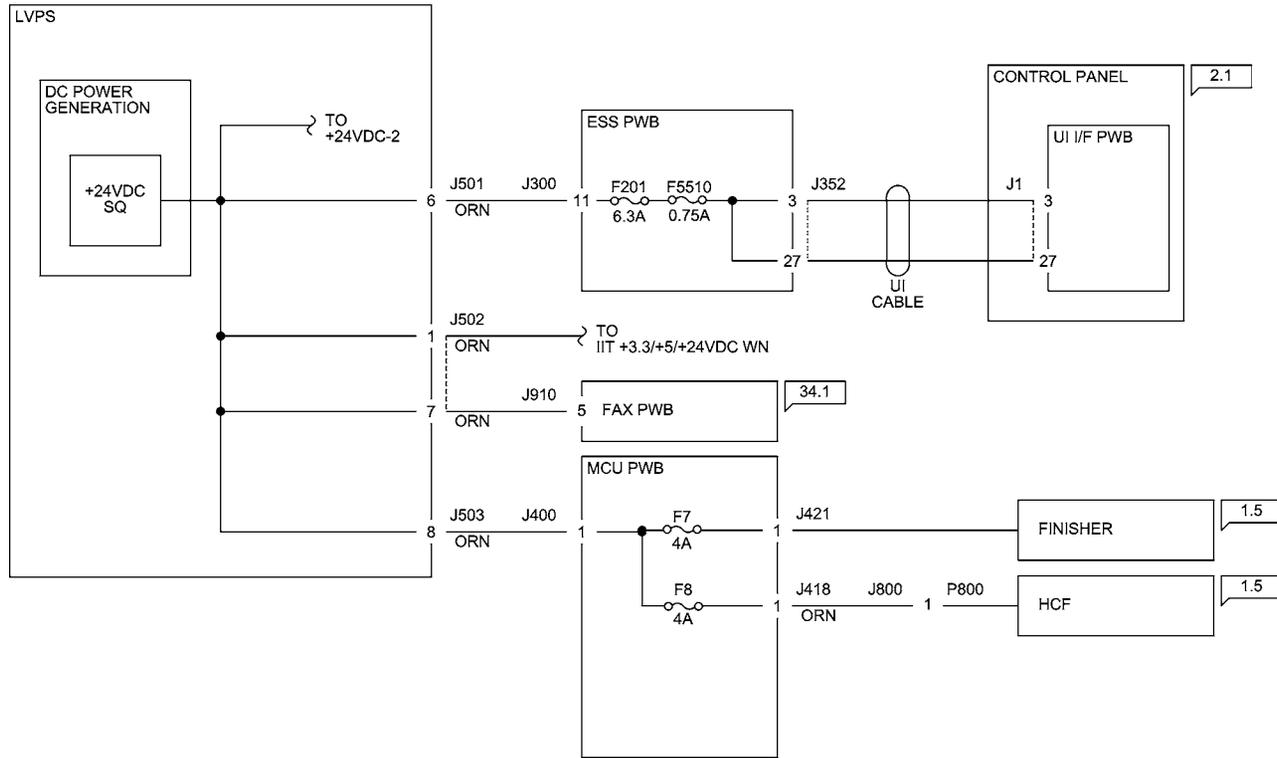
Figure 9 +24 VDC Wirenet (1 of 2)

+24VDC WIRENET (1 OF 2)

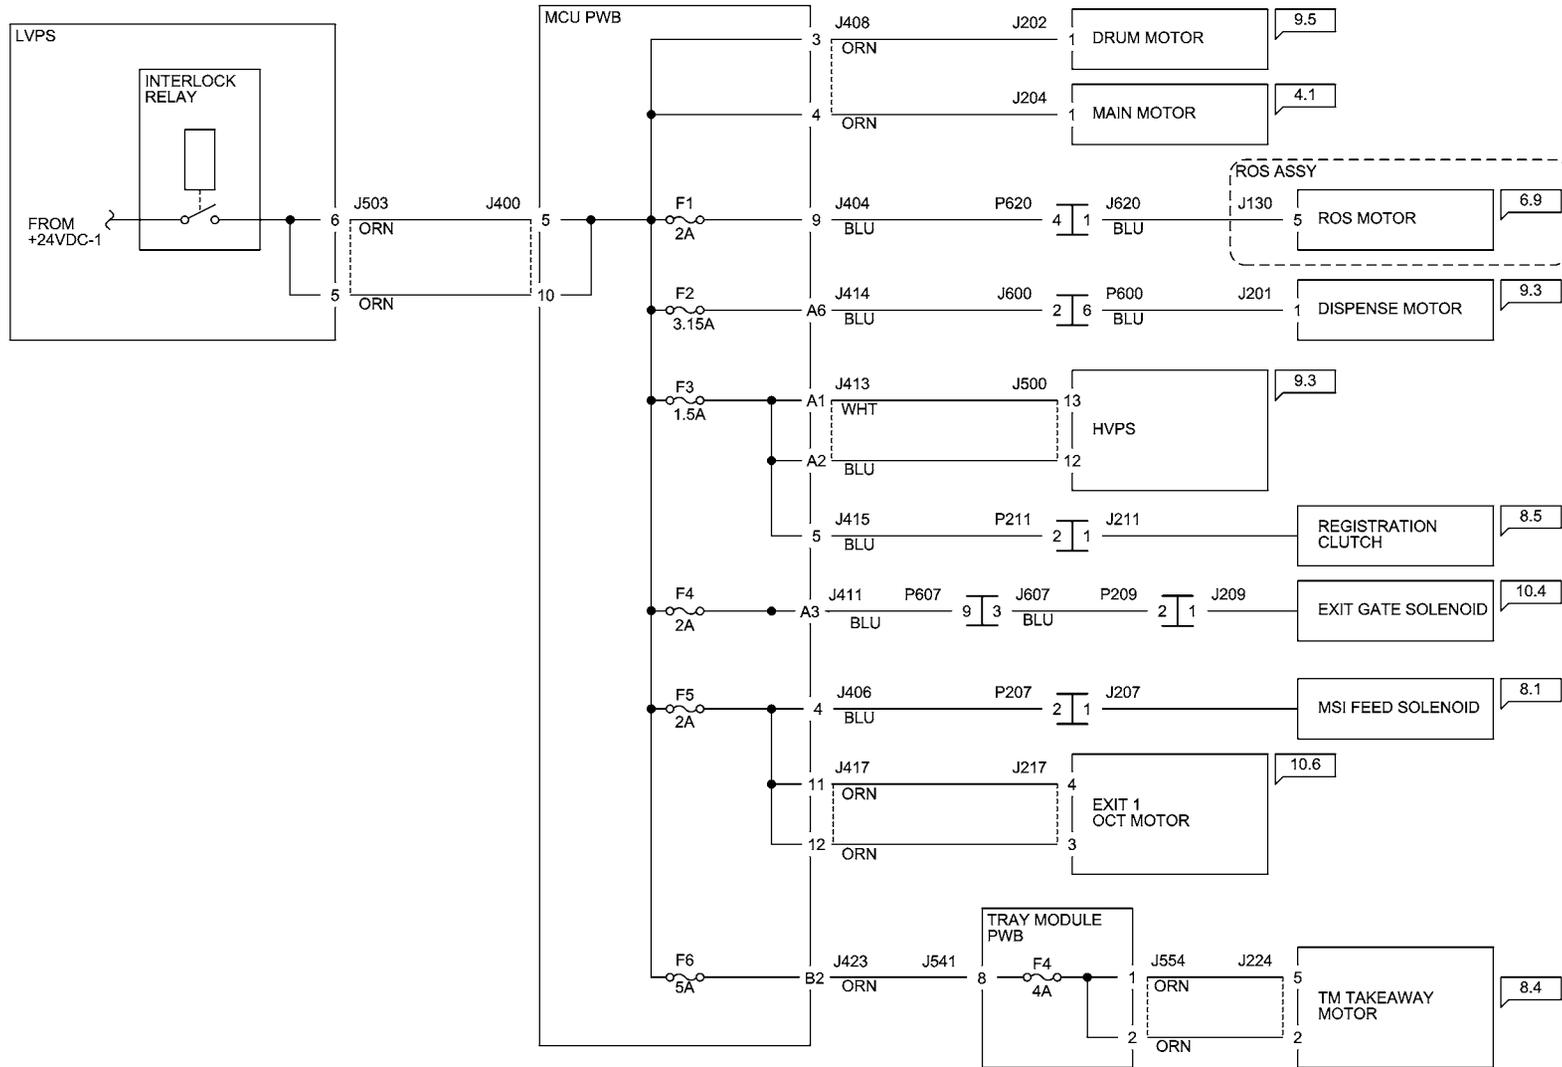
Figure 10 +24 VDC Wirenet (2 of 2)

+24 VDC WIRENET (2 OF 2)

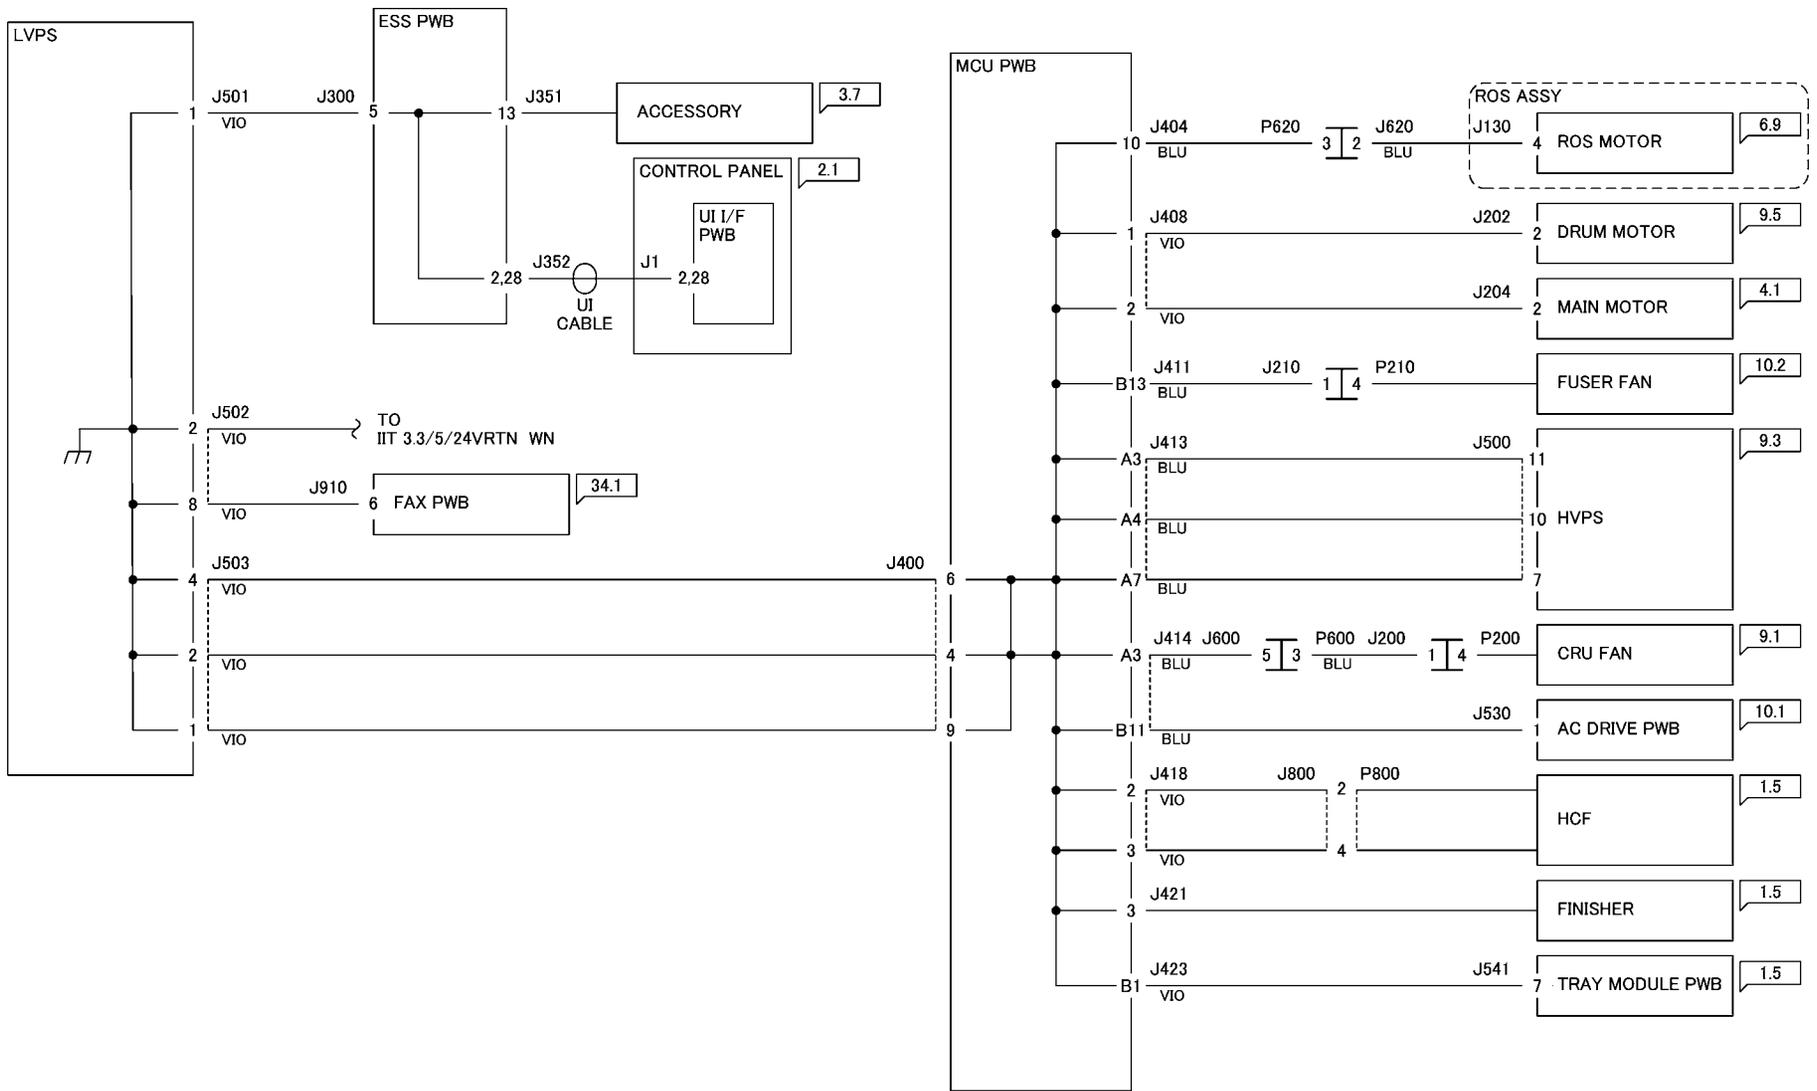
Figure 11 24V RTN Wirenet

24V RTN WIRENET

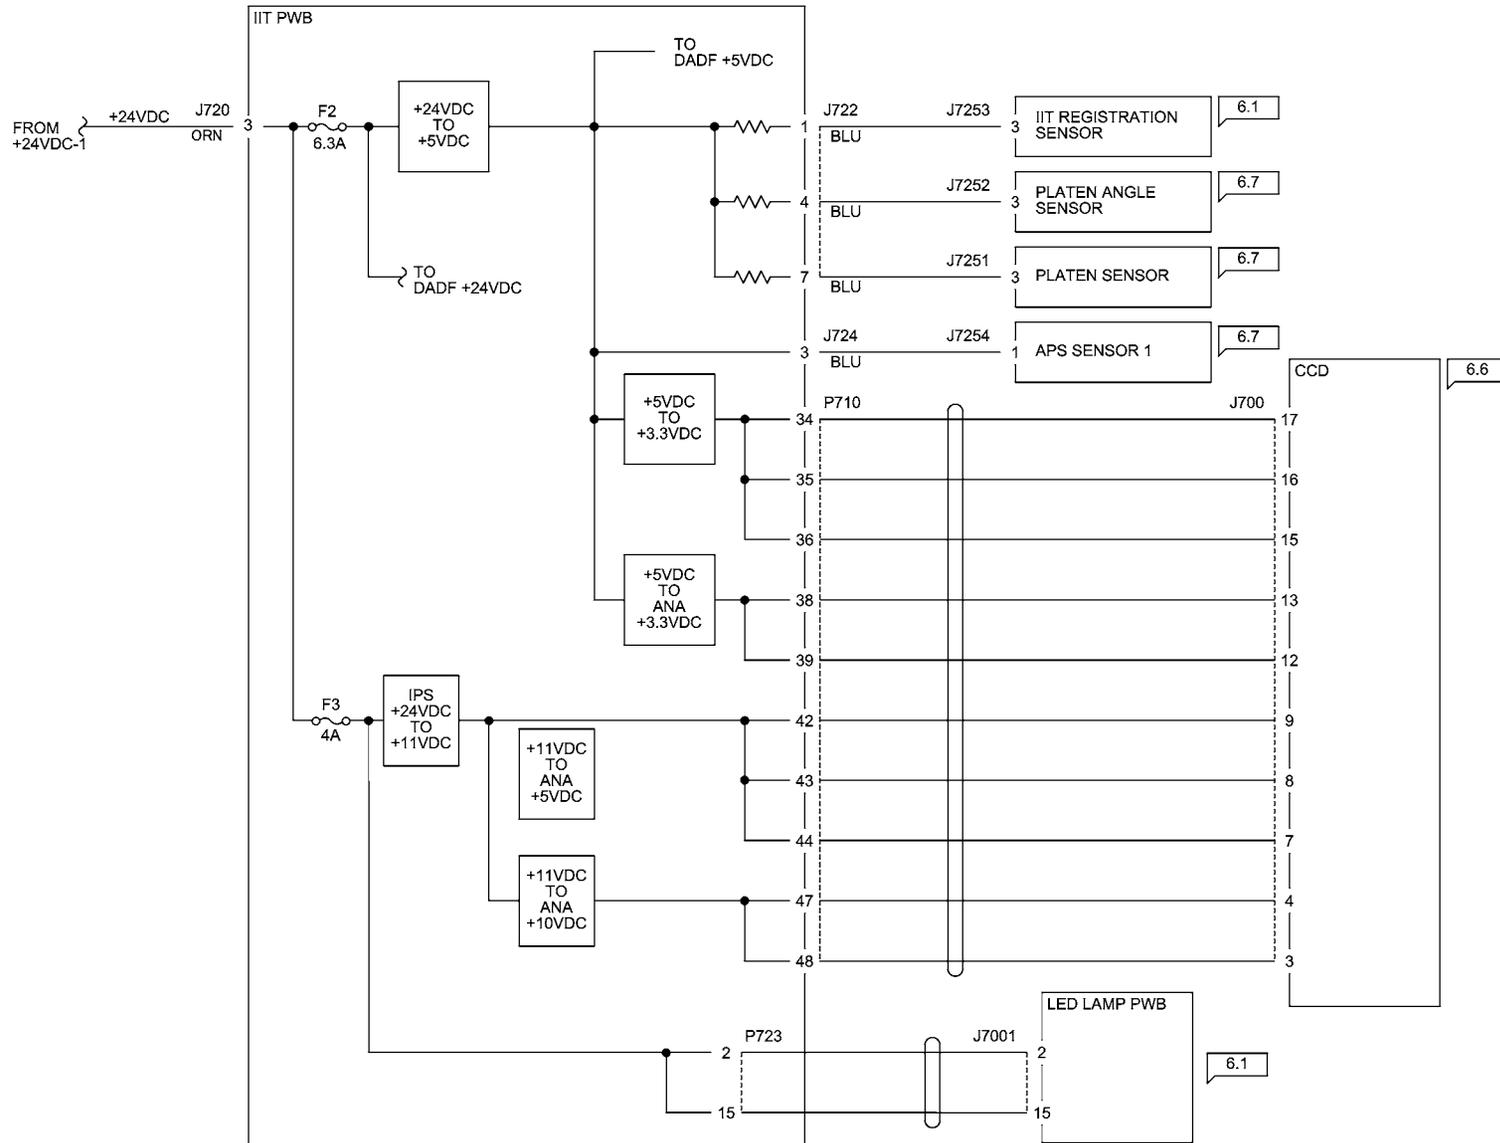
Figure 1 IIT +3.3/+5/+24 VDC Wirenet

IIT +3.3/+5/+24VDC WIRENETS

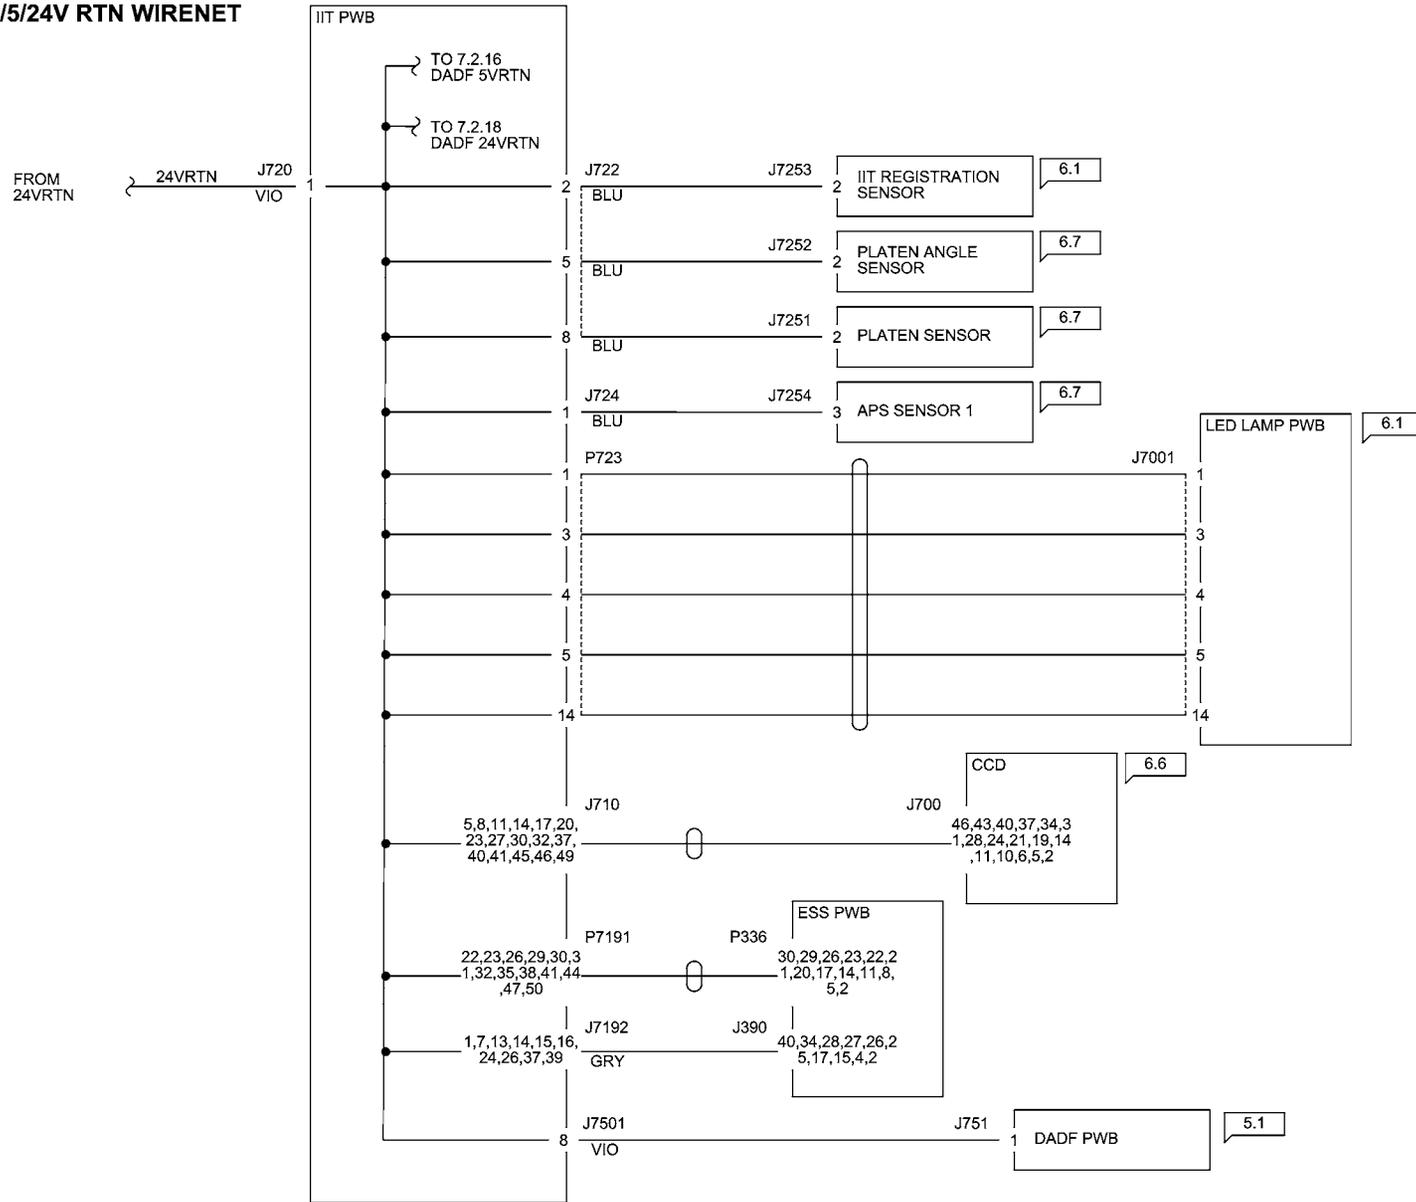
Figure 2 IIT 3.3/5/24V RTN Wirenet

IIT 3.3/5/24V RTN WIRENET

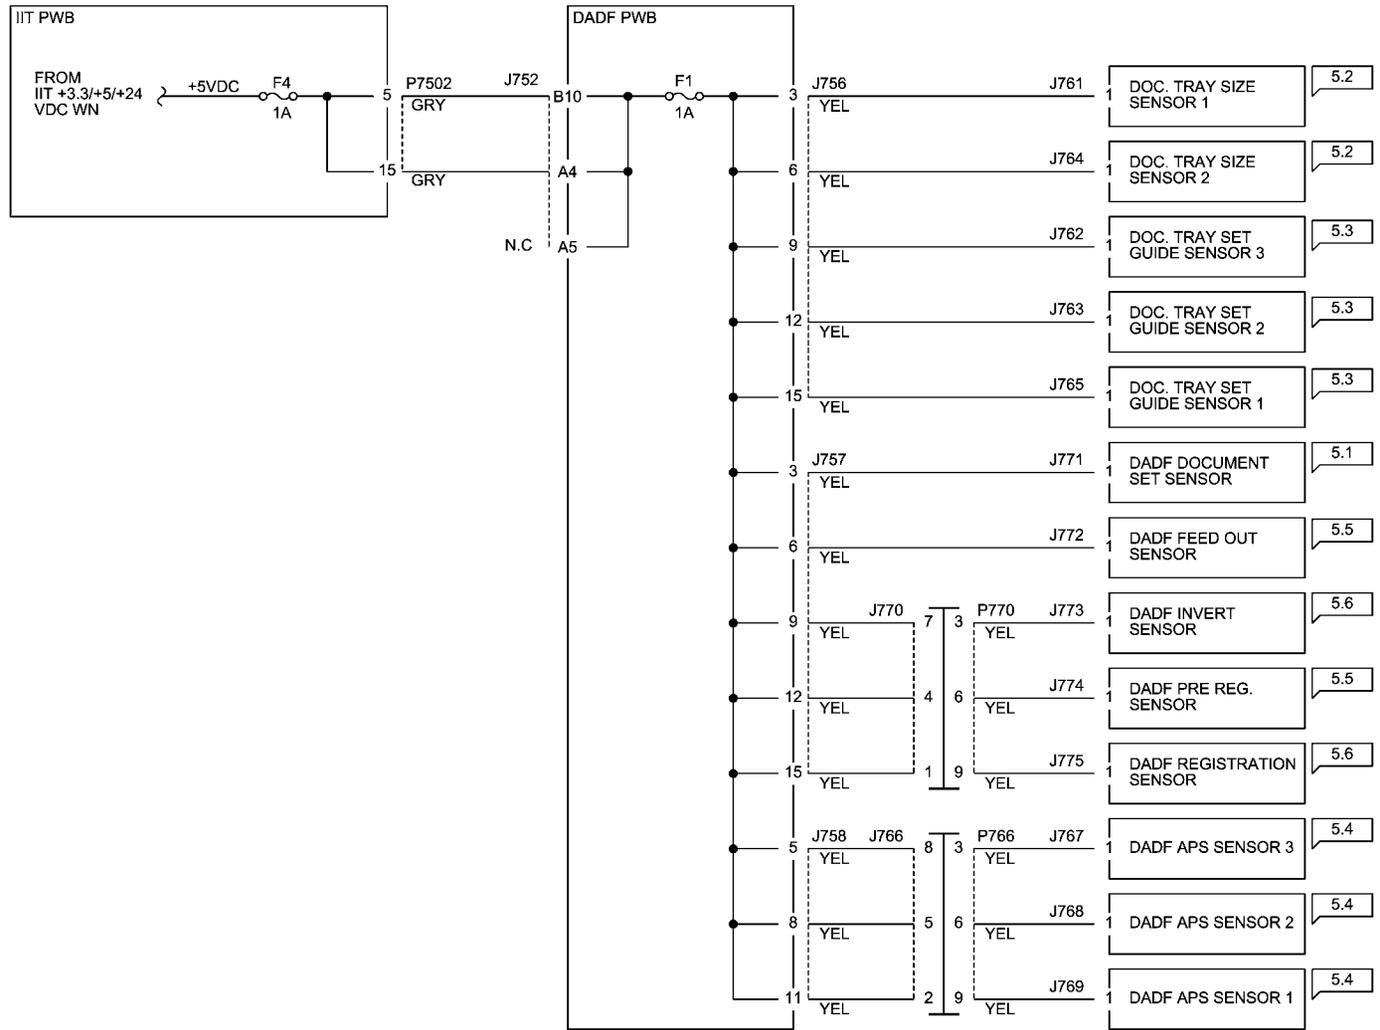
Figure 3 DADF +5VDC Wirenet

DADF +5VDC WIRENET
