WorkCentre 5335 Family Service Documentation

705P01303

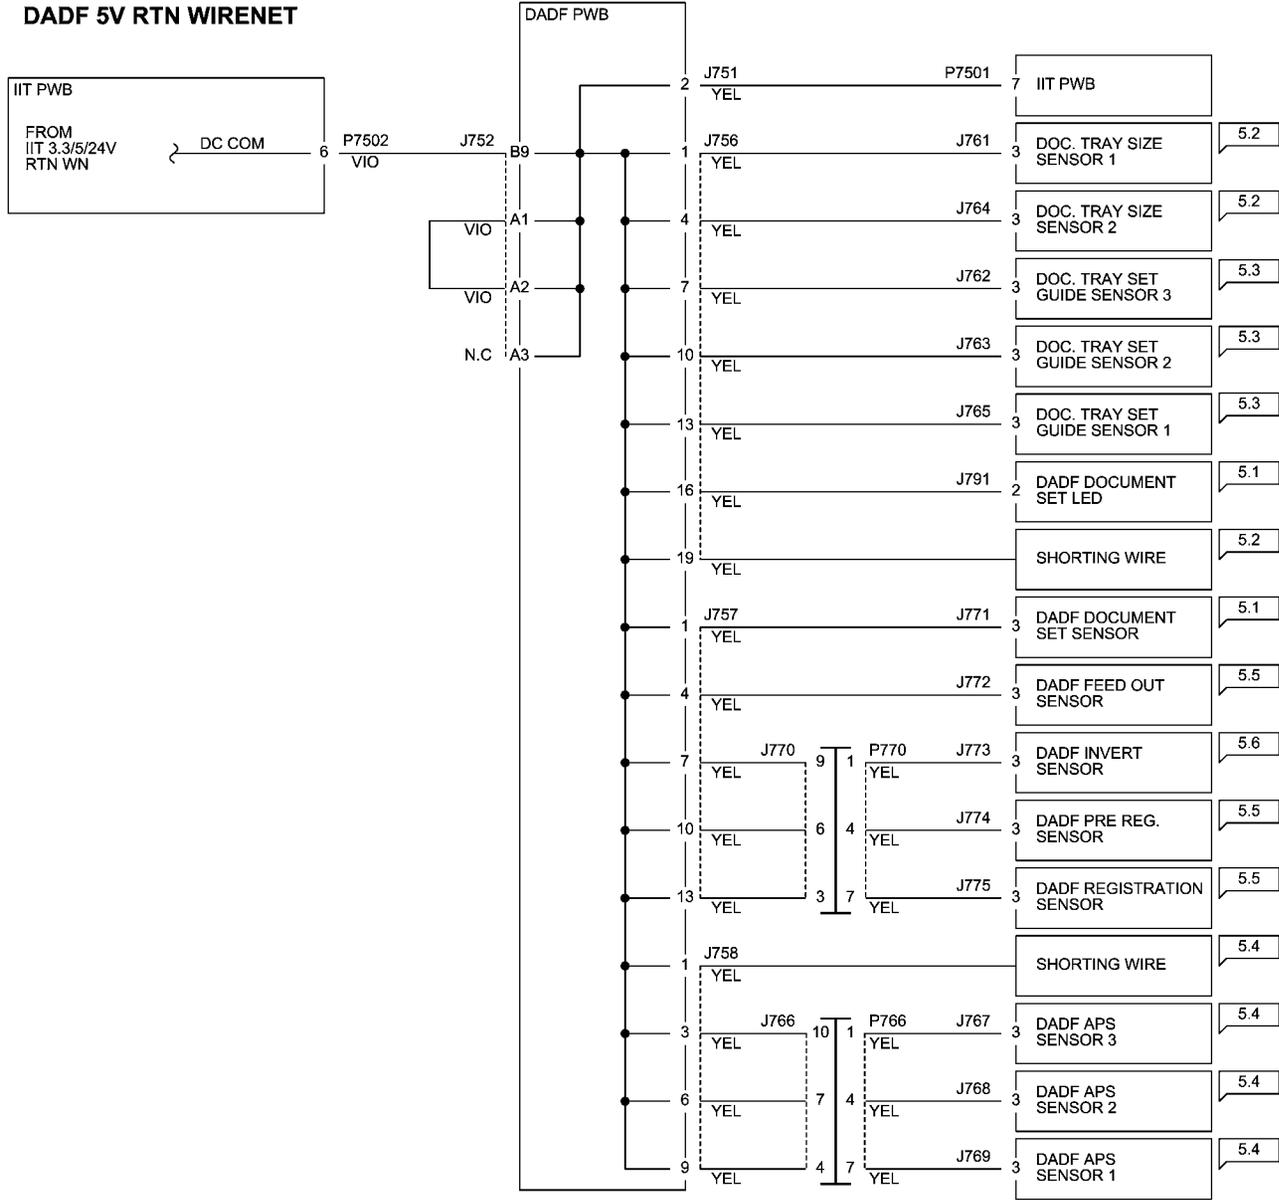
Figure 4 DADF 5V RTN Wirenet

DADF 5V RTN WIRENET

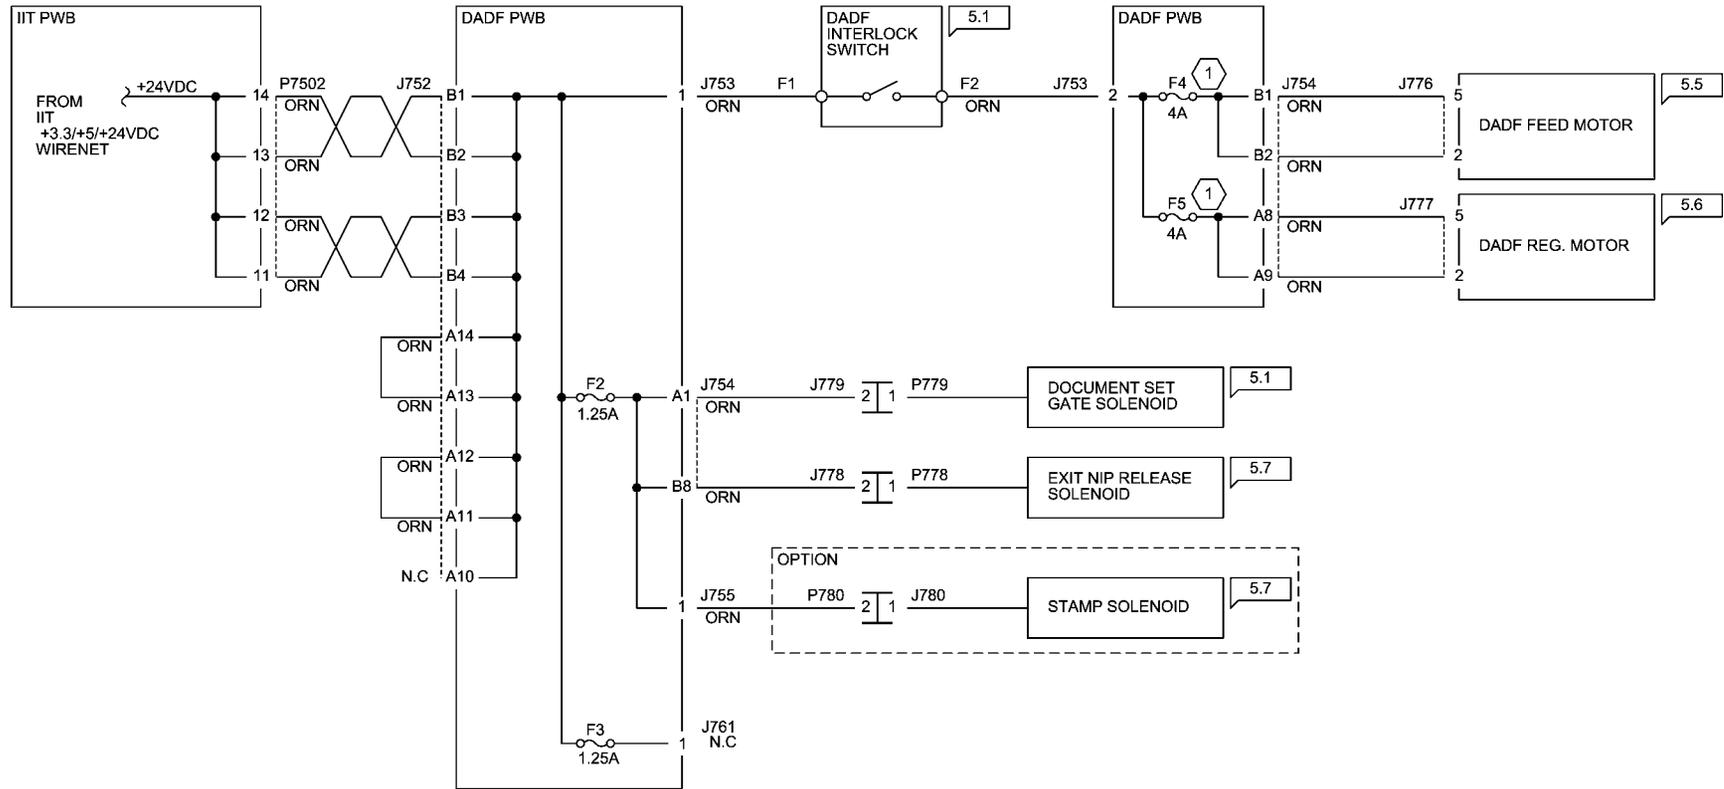
Figure 5 DADF +24VDC Wirenet

DADF +24VDC WIRENET

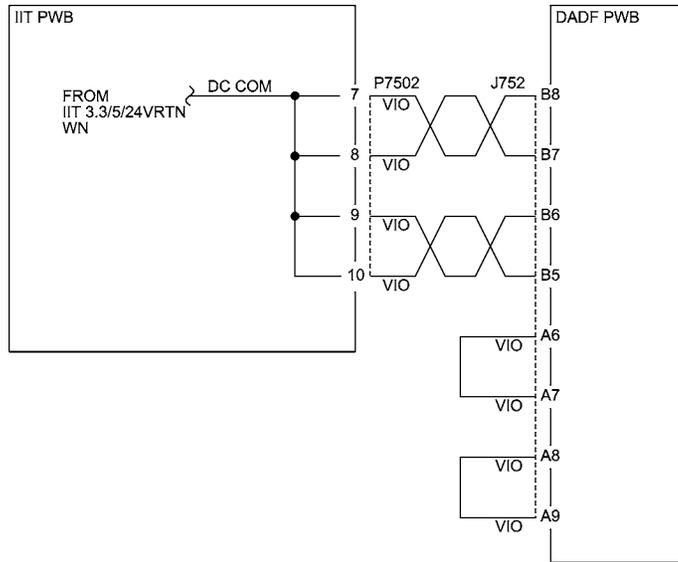
Figure 6 DADF 24V RTN Wirenet

DADF 24V RTN WIRENET

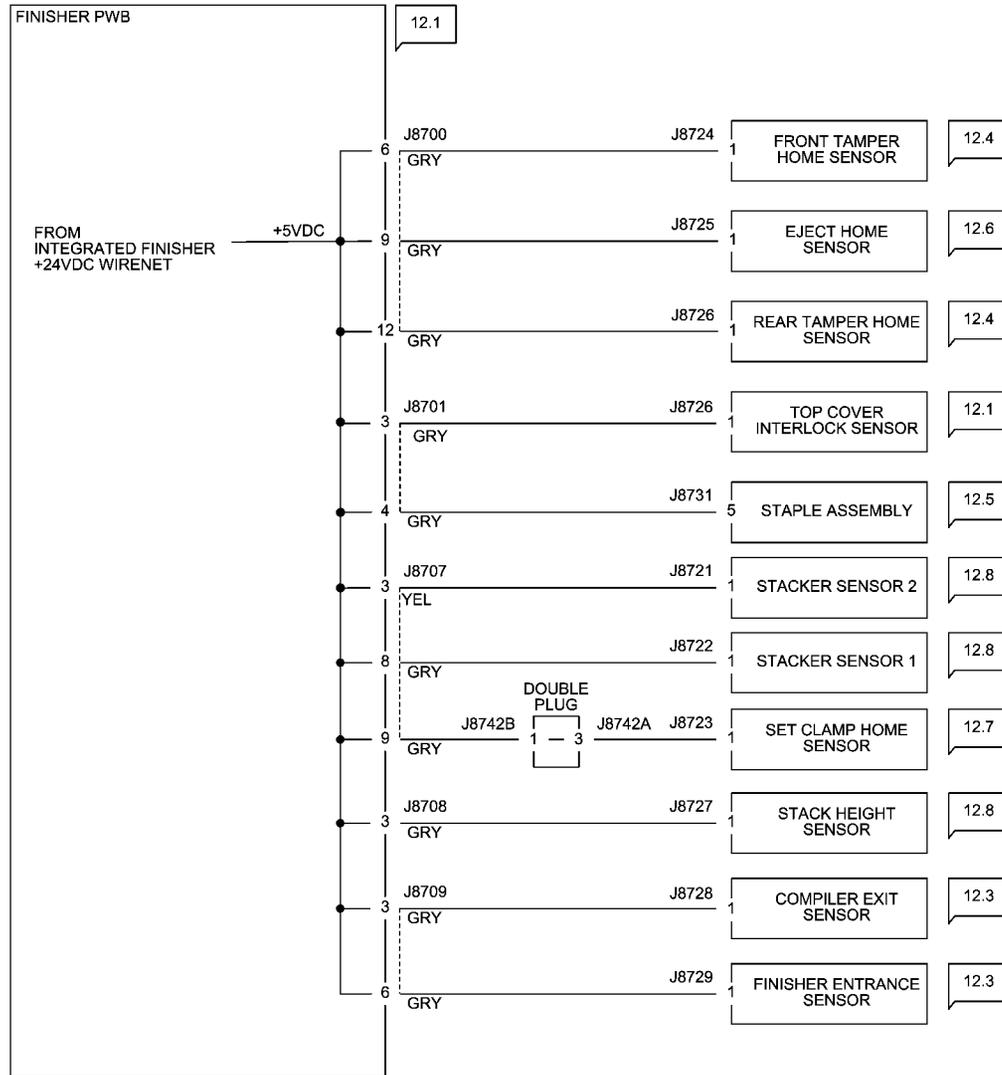
Figure 1 Integrated Office Finisher +5VDC Wirenet

INTEGRATED OFFICE FINISHER +5VDC WIRENET

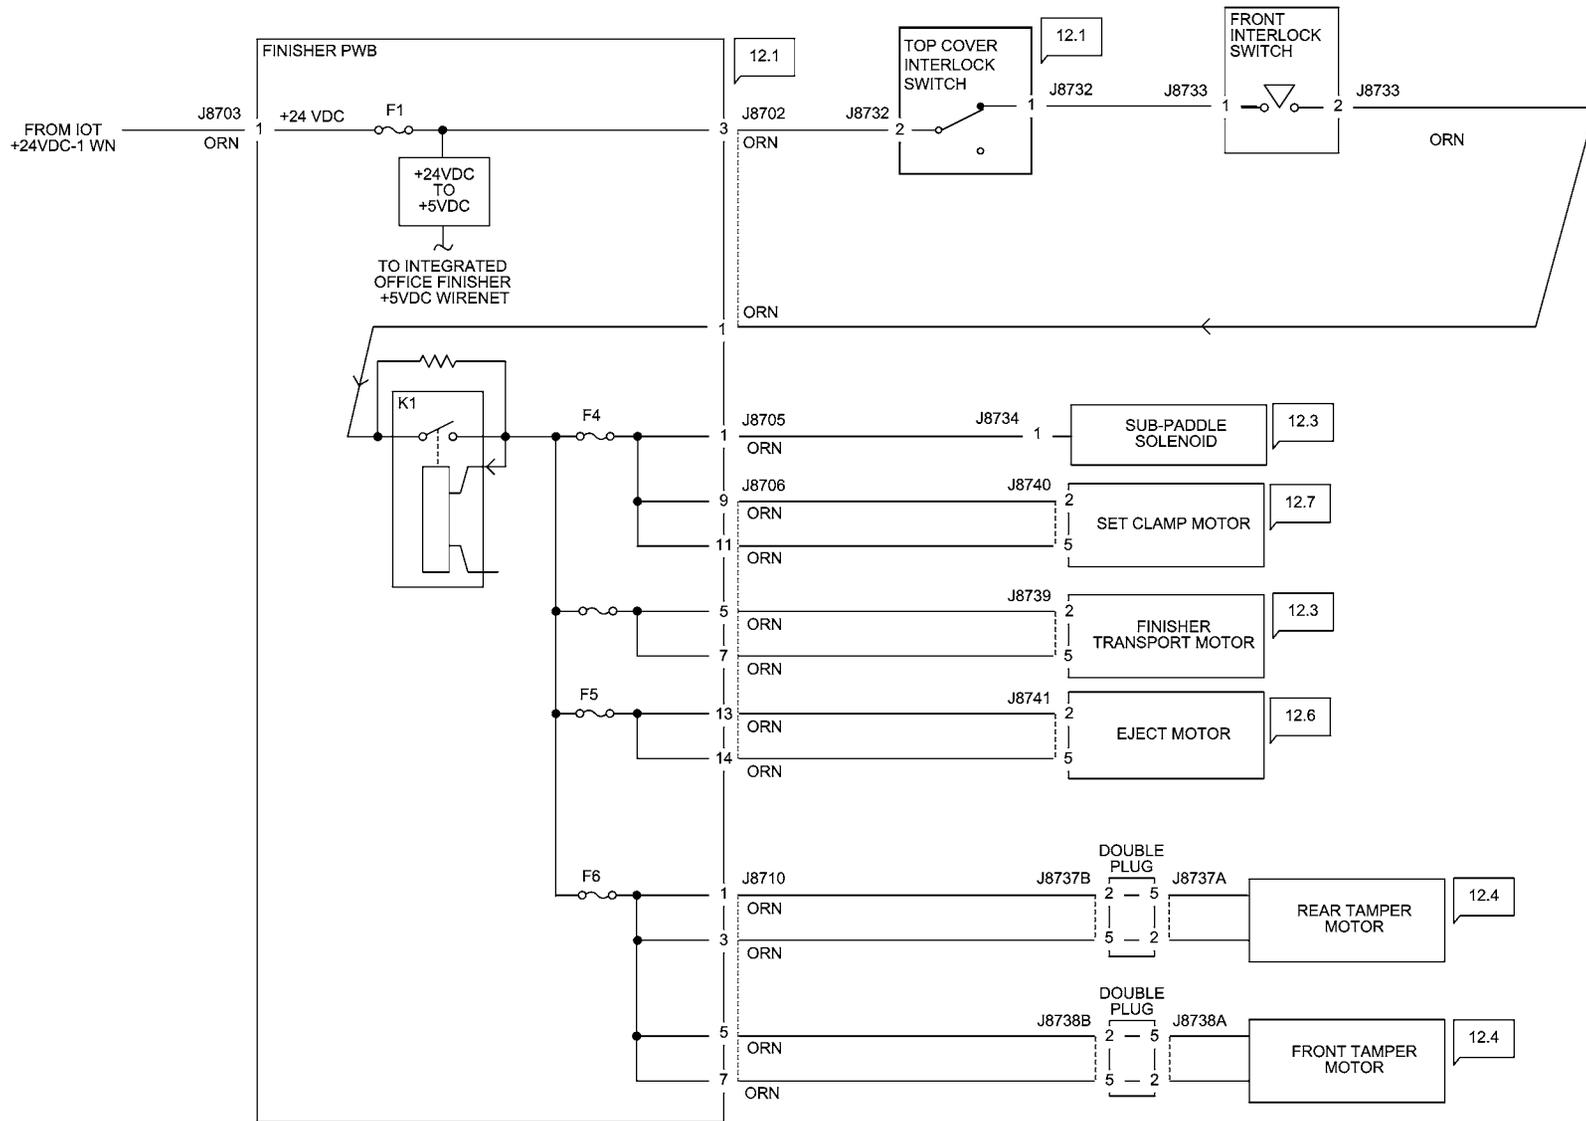
Figure 2 Integrated Office Finisher +24VDC Wirenet

INTEGRATED OFFICE FINISHER +24VDC WIRENET

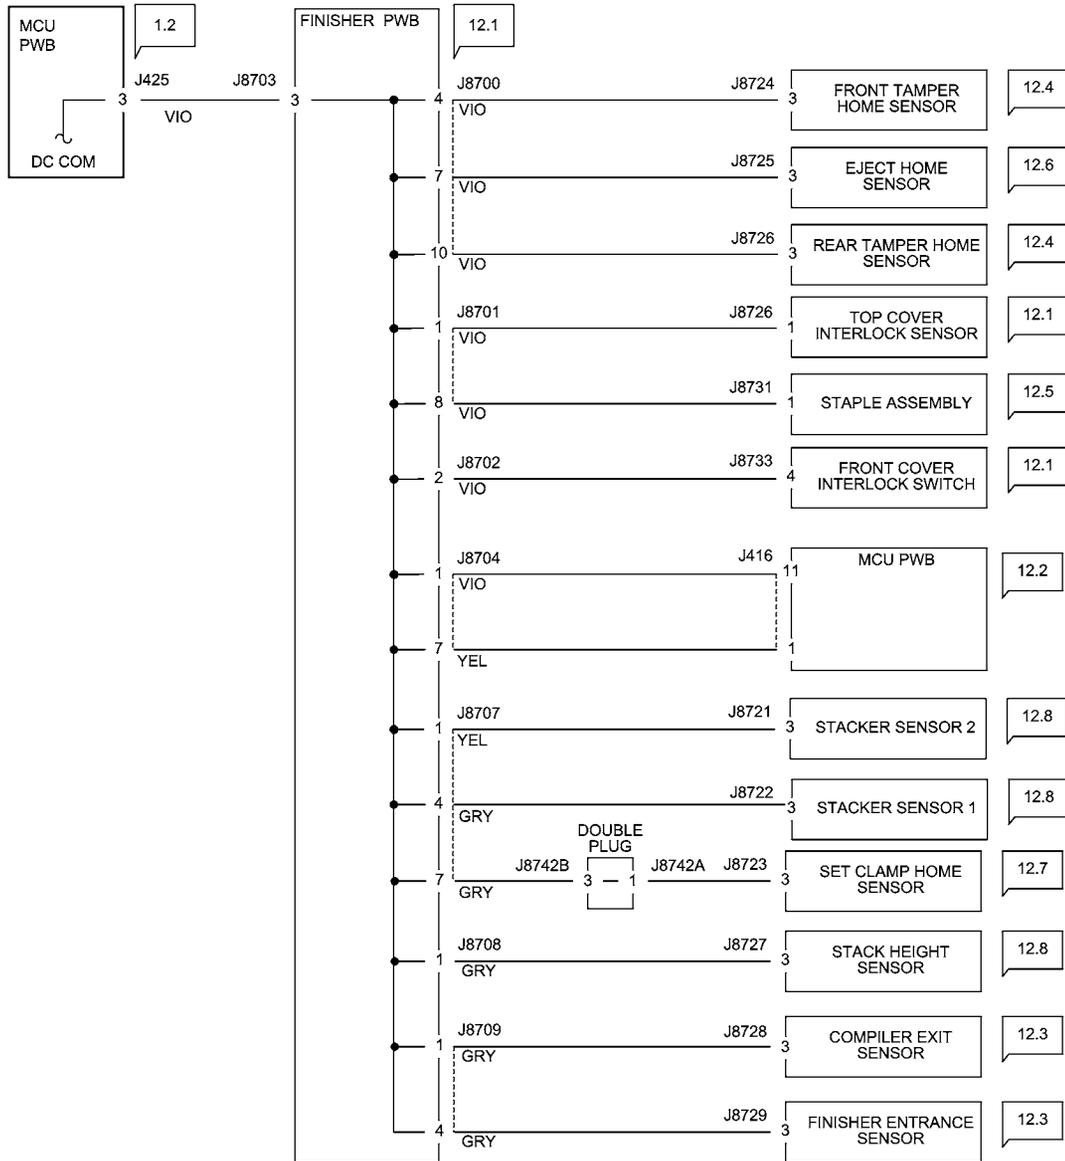
Figure 3 Integrated Office Finisher DC RTN Wirenet

INTEGRATED OFFICE FINISHER DC RTN WIRENET

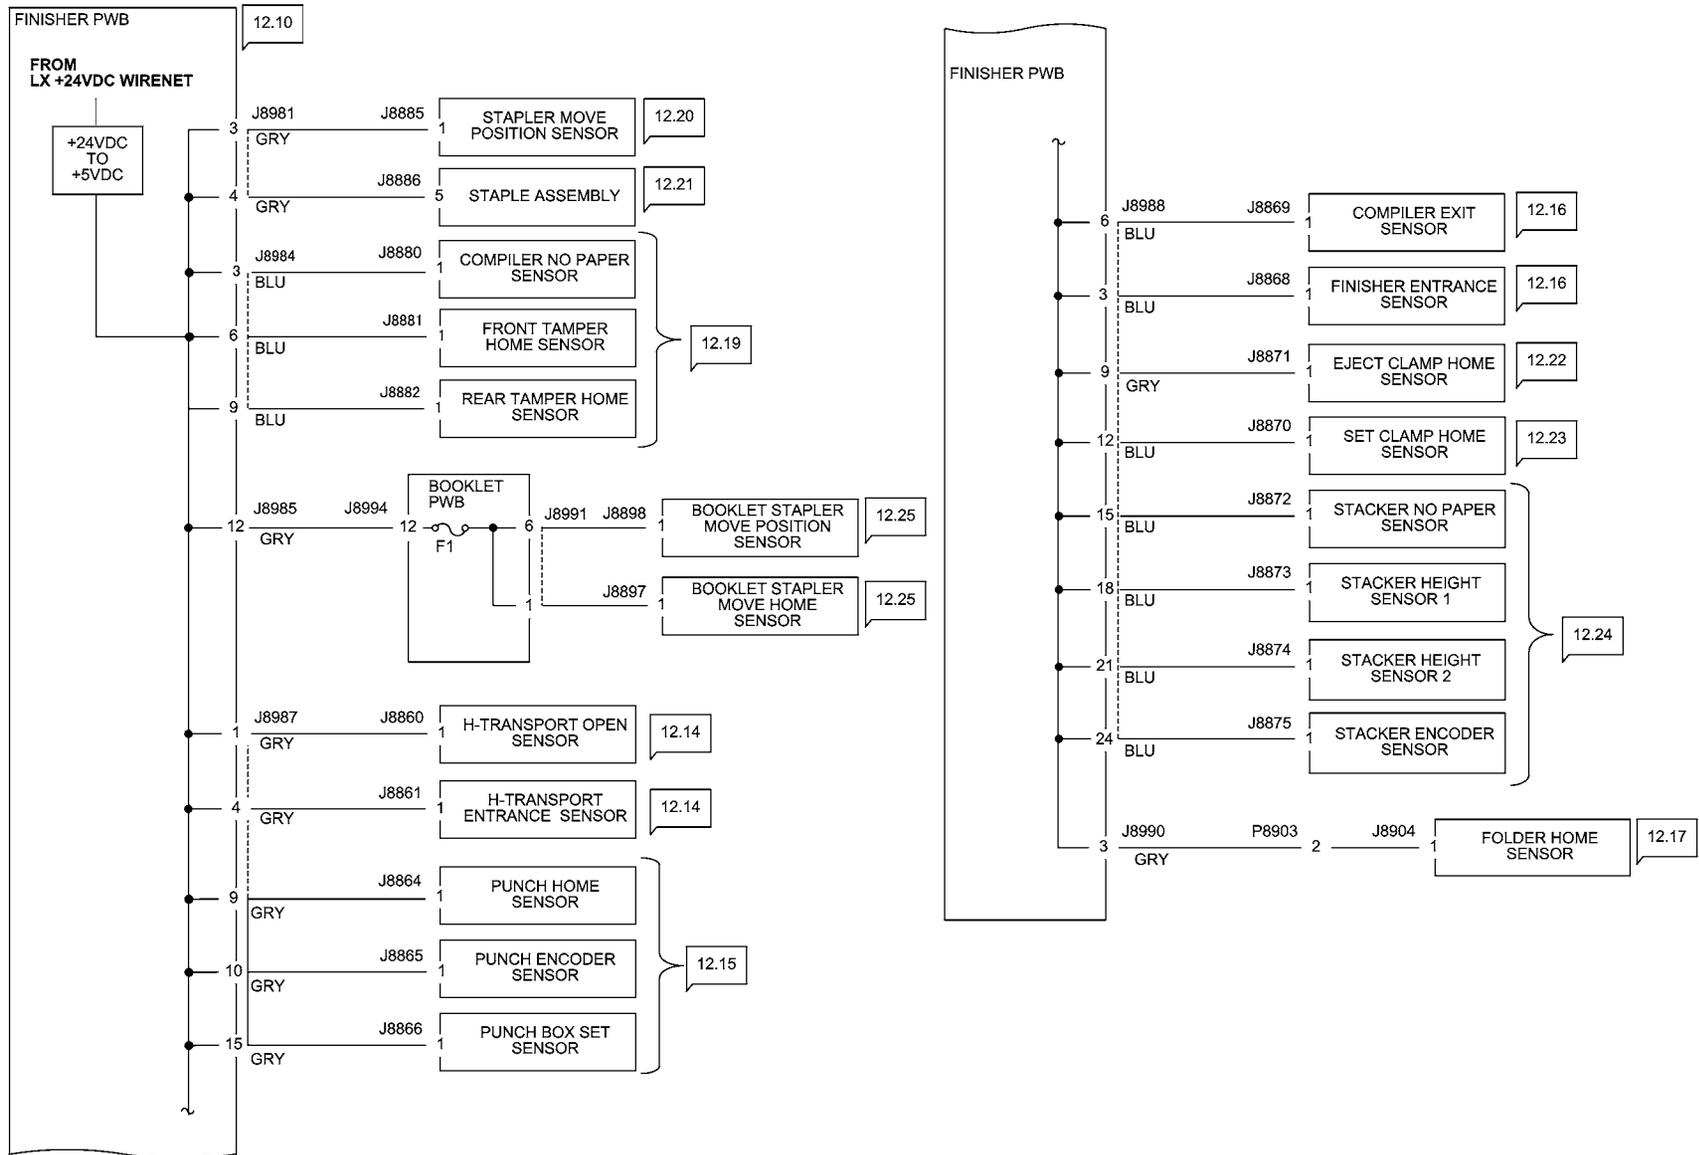
Figure 1 Office Finisher LX +5VDC Wirenet

OFFICE FINISHER LX +5VDC WIRENET

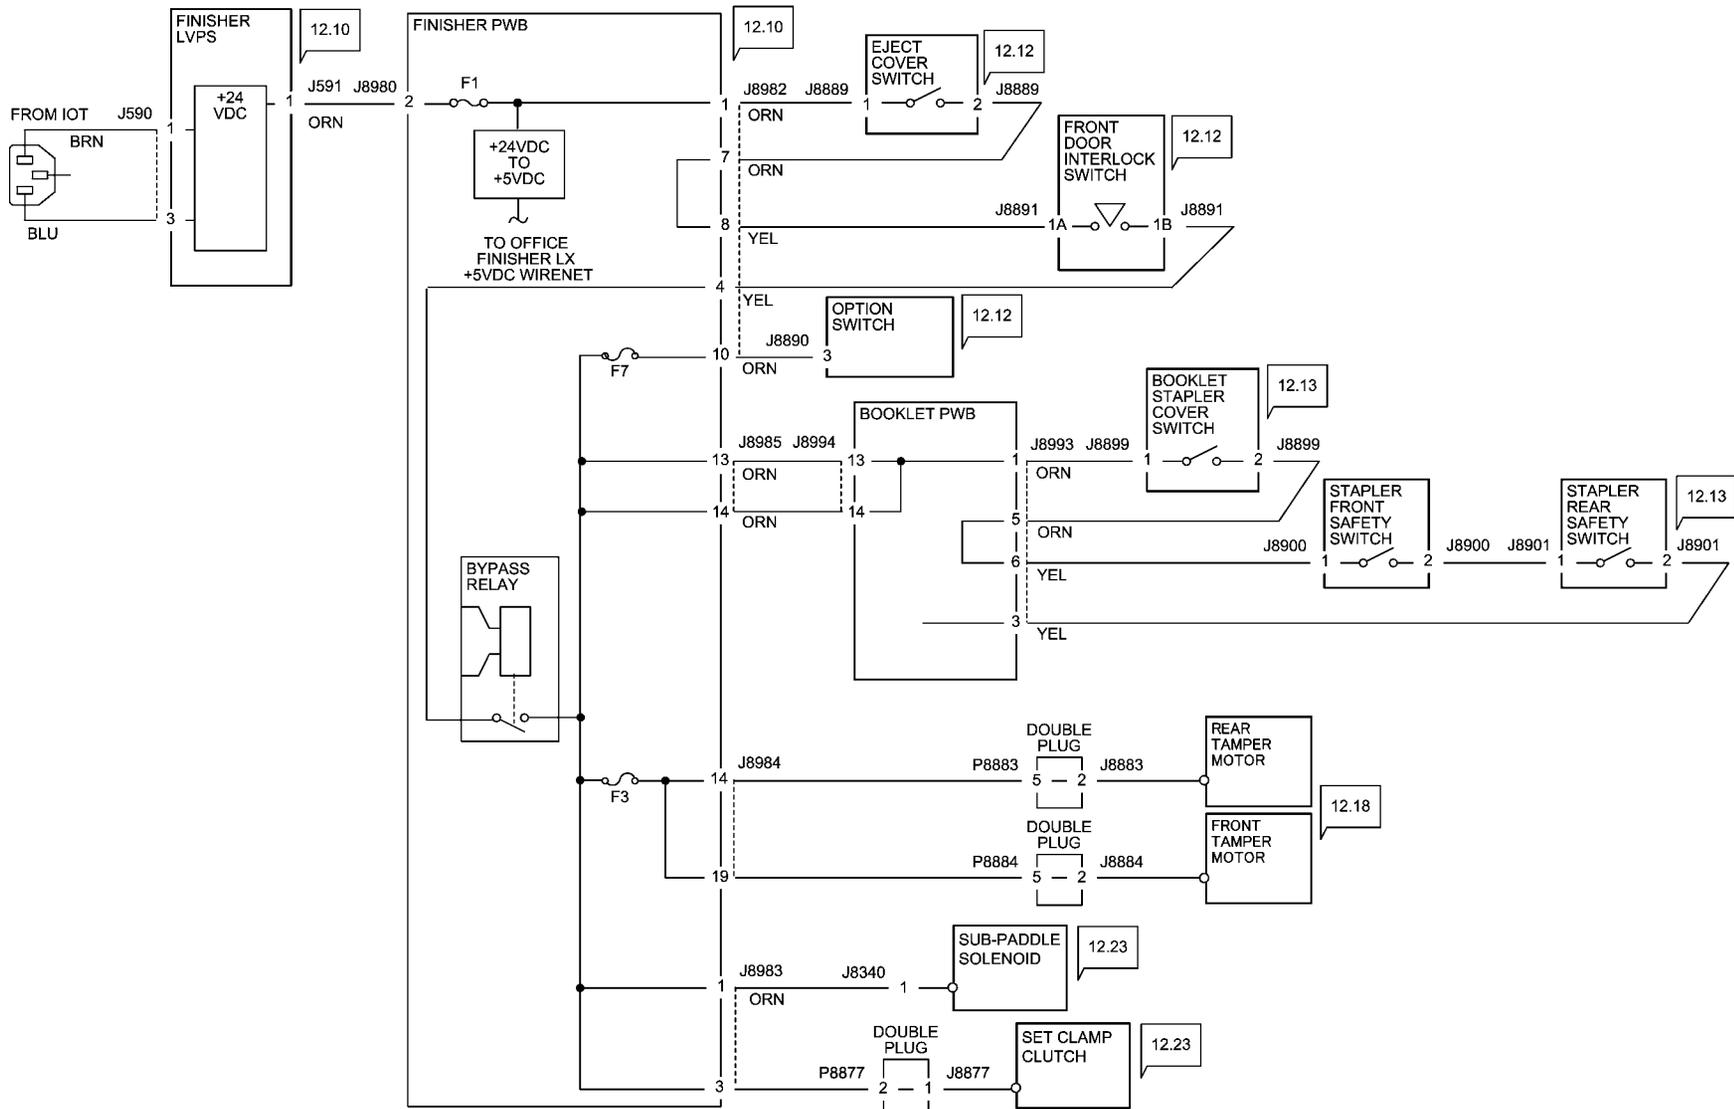
Figure 2 Office Finisher LX +24VDC Wirenet

OFFICE FINISHER LX +24VDC WIRENET

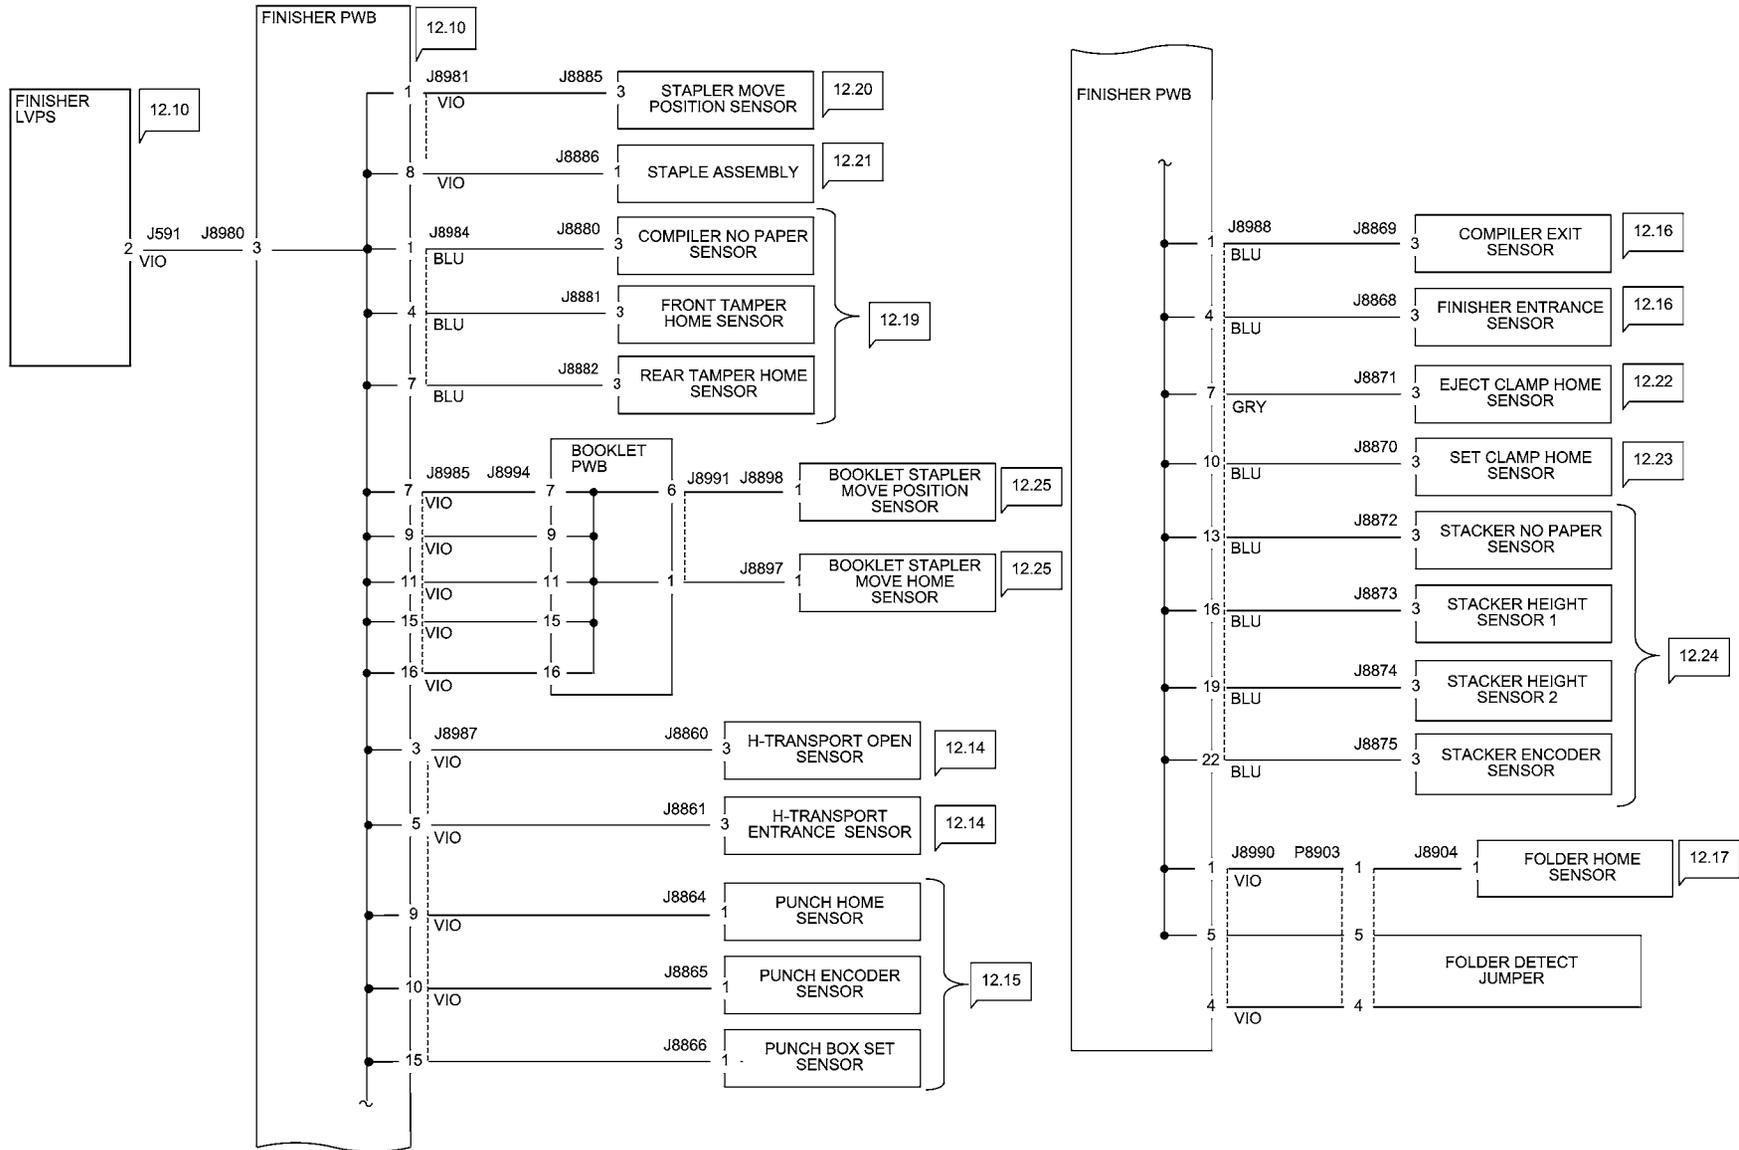
Figure 3 Office Finisher LX DC RTN Wirenet

OFFICE FINISHER LX DC RTN WIRENET
