Troubleshooting: ORU
Model Name:
Pro C651EX/Pro C751EX/Pro C751

Introduction

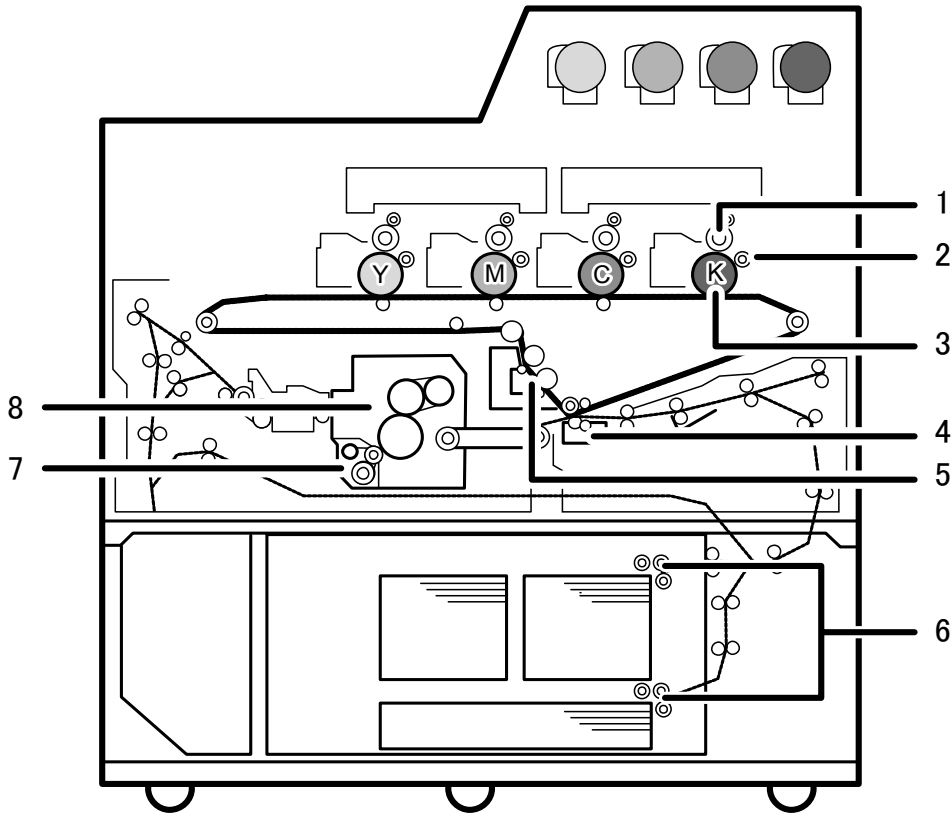
CEZ591

This section introduces the names of the components.

Refer to the following diagrams when replacing units or troubleshooting.

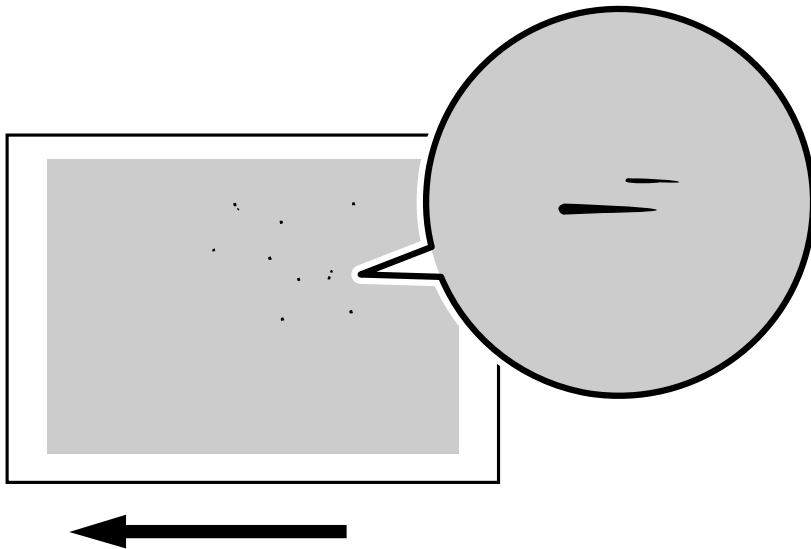
3.1.1 Paper Is Spotted with Toner

Paper is soiled with toner spots of 0.5–1 mm (0.02–0.04 inches) in diameter.

Toner fragments have slipped through the cleaning web.

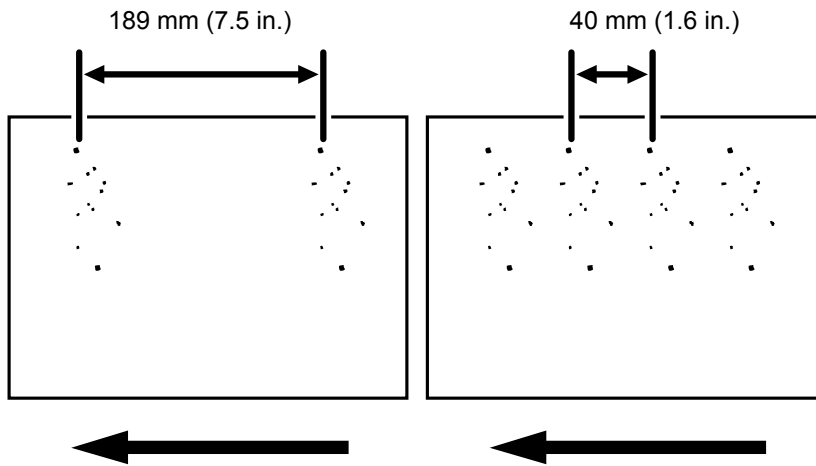
CEZ539

3.1.2 Coloured Spots

Coloured spots appear at 189 mm or 40 mm (7.5 inches or 1.6 inches) intervals.

- (a) Coloured spots appear at 189 mm (7.5 inches) intervals
The drum unit is scratched or stained.
- (b) Coloured spots appear at 40 mm (1.6 inches) intervals
The charge roller is scratched or stained.

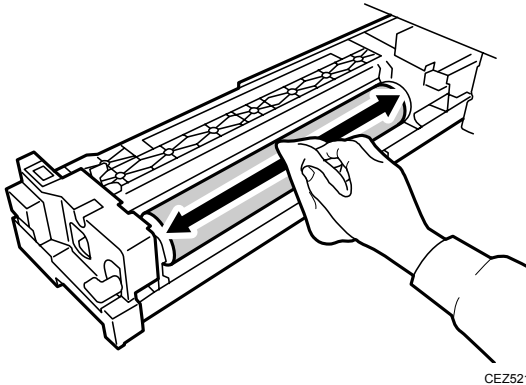
No Wipe the drum surface with a well-wrung-out damp cloth, wipe it with a dry rag until no moisture remains, and then reattach the drum unit.

- Do not use ethanol or any other organic solvent to clean the drum. Otherwise it may cause damage to the drum.

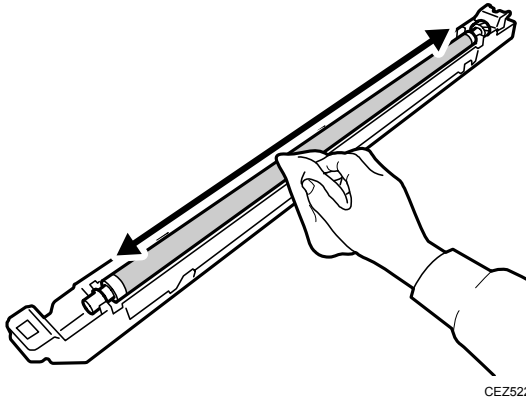
CEZ522

No Wipe the charge roller surface with a well-wrung-out damp cloth, wipe it with a dry rag until no moisture remains, and then reattach the roller.

- Do not use ethanol or any other organic solvent to clean the charge roller. Otherwise it may cause damage to the charge roller.

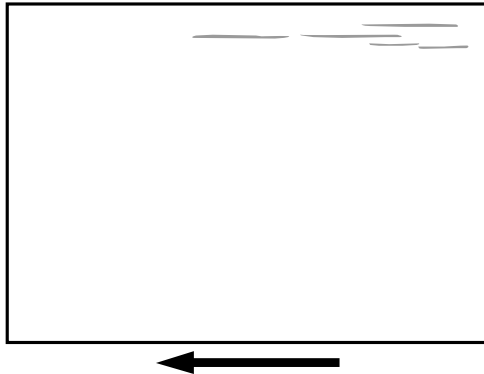
3.1.3 Coloured Streaks (1)

Coloured streaks parallel to the paper feed direction appear.

- The charge roller is stained.
- The cleaning unit for PCU has worn out.
- The drum unit surface is scratched.

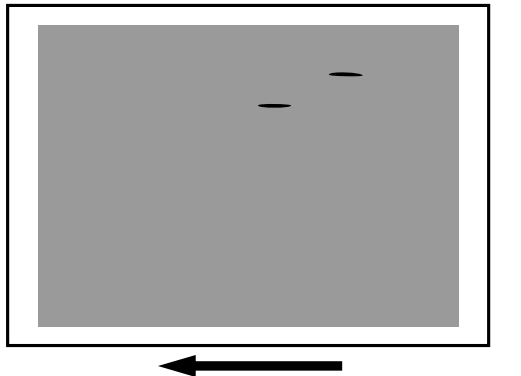
3.1.5 Coloured Streaks (3)

Coloured streaks appear in solid-filled areas.

If the toner contains small clumps, they disintegrate in the development unit, producing coloured streaks.

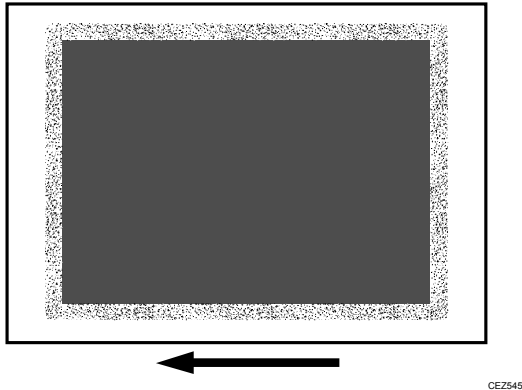
3.2.1 Area Scatter

Toner is scattered around a solid-fill print.

This may occur if printed at low temperature or humidity.

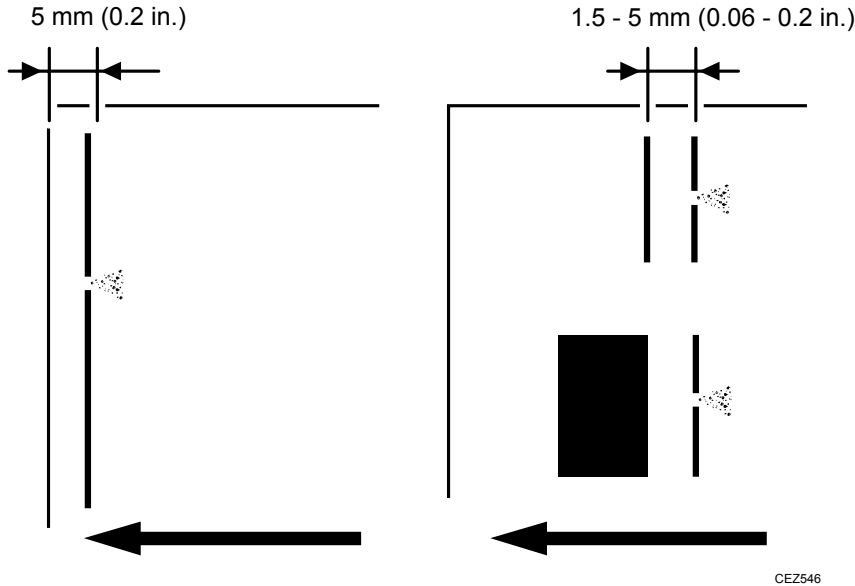
CEZ546

3.2.2 Line Scatter

Parts of a line exhibit splatter. This may occur in a line 5 mm or less from the leading edge, or in a line 1.5 to 5 mm from an image element on the side of the element facing the trailing edge.

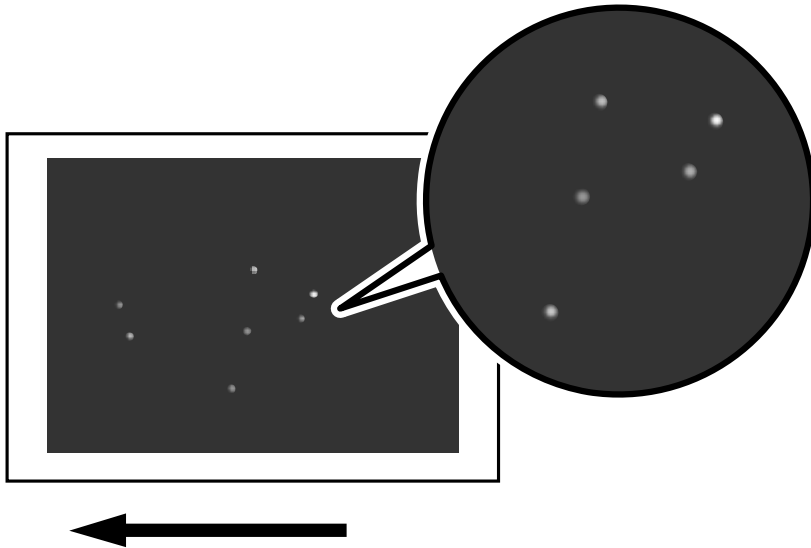
CEZ547

3.3.1 Colourless Spots

Colourless spots appear in solid-filled areas.

If the toner contains small clots, they fail to be transferred, producing colourless spots.

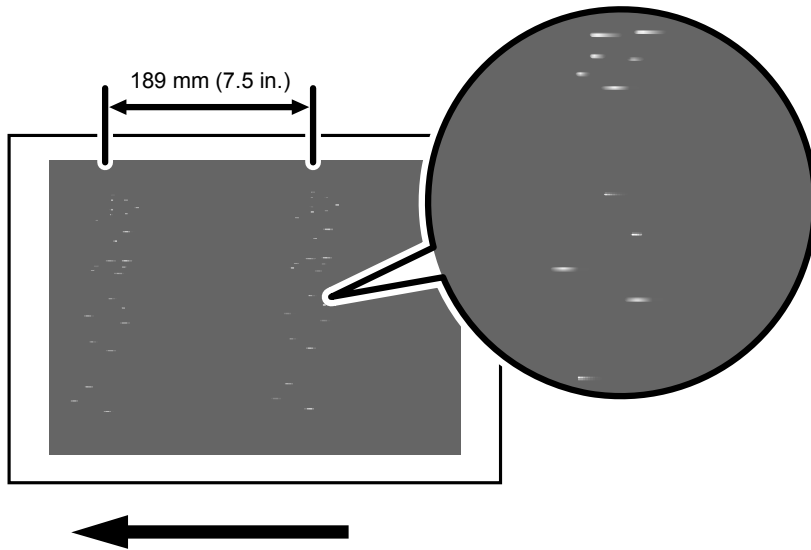
CEZ548

3.3.2 White Dots/Lines

White dots or small lines appear, spaced at 189 mm (7.5 inches) intervals in the direction of the paper feed.

Cause: The drum unit is stained.

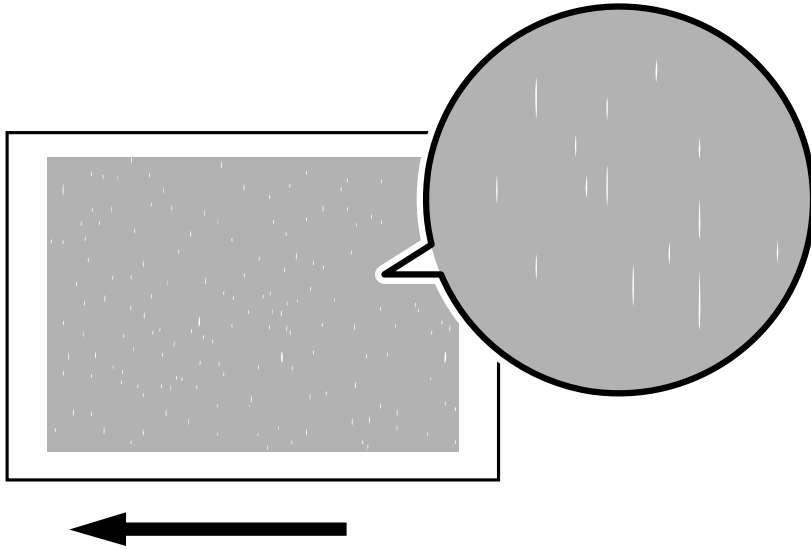
CEZ604

3.3.3 Vertical White Streaks

White streaks 1 to 8 mm long perpendicular to the paper feed direction appear.

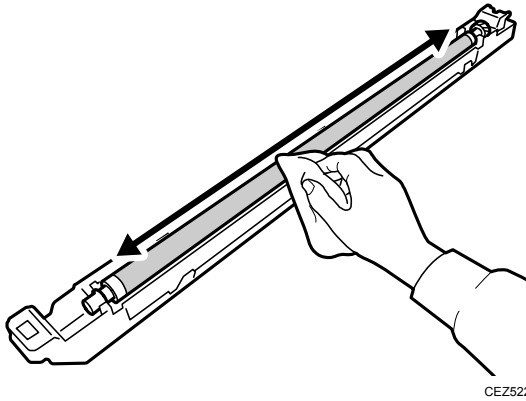
1. To identify the affected colour, print three full-page, halftone A3 or DLT sheets for each of cyan, magenta, yellow, and black.
2. Detach the charge roller of the affected colour, wipe its surface with a well-wrung-out damp cloth, wipe it with a dry cloth until no moisture remains, and then reattach the roller.

Do not use ethanol or any other organic solvent to clean the charge roller. Otherwise it may cause damage to the charge roller.

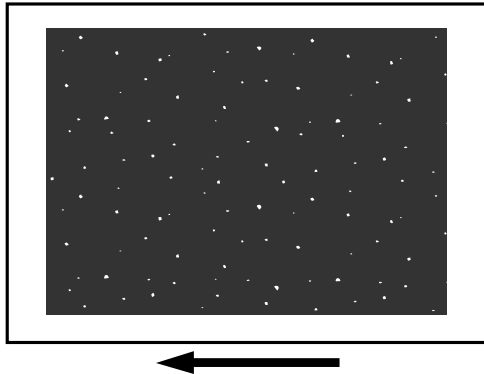
CEZ549

3.3.4 White Spots

White spots of 0.2–0.3 mm (0.008–0.01 inches) in diameter appear.

This may occur if printed at low temperature or humidity.

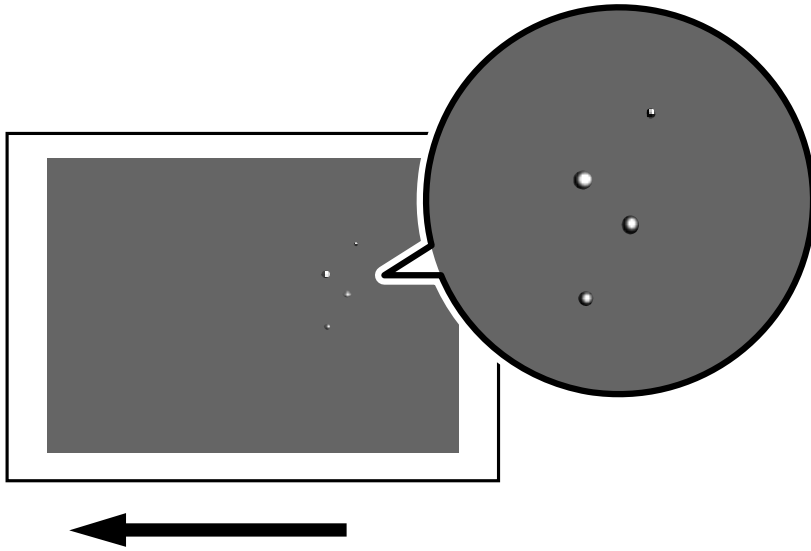
CE2602

3.3.5 Blister-like White Spots

White spots 0.3–0.5 mm in diameter surrounded by denser spots (blister-like white spots) appear.

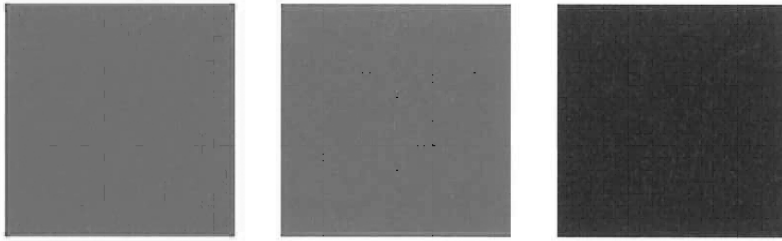
Normal

Mottling occurs in solid-filled areas.

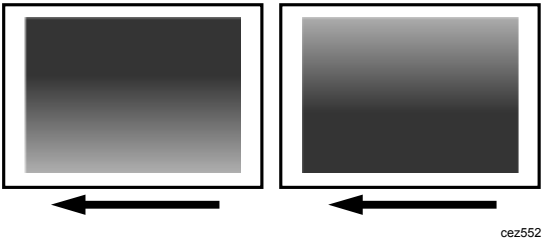
Affected area		Solution
The density from top to bottom is uneven.

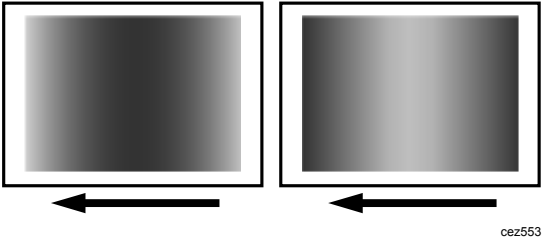
<ol style="list-style-type: none"> 1. In the [Adjustment Settings for Skilled Operators] menu, execute [0201: Adjust Image Density]. 2. If the problem persists, see p.37, "Uneven Density from Top to Bottom".
The sides are fainter or denser.

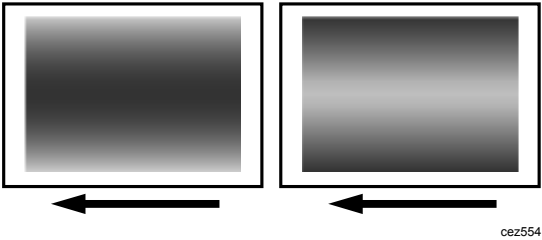
<ol style="list-style-type: none"> 1. In the [Adjustment Settings for Skilled Operators] menu, execute [0201: Adjust Image Density]. 2. If the problem persists, contact your service representative.
The top and bottom are fainter or denser.

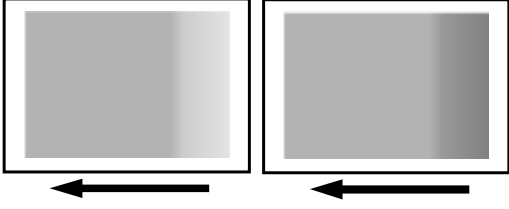
<p style="text-align: right; font-size: small;">cez556</p>	<ol style="list-style-type: none"> 1. In the [Adjustment Settings for Skilled Operators] menu, execute [0201: Adjust Image Density]. 2. If the problem persists, see p.40, "Fainter Trailing Edge".
The area within 90 mm (3.5 inches) of the trailing edge is fainter or denser.

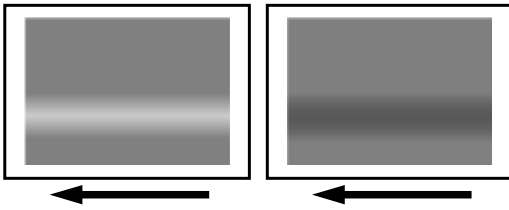
The centre is fainter or denser

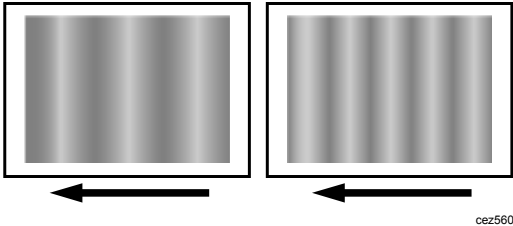
Affected area		Solution
Periodic vertical density fluctuation

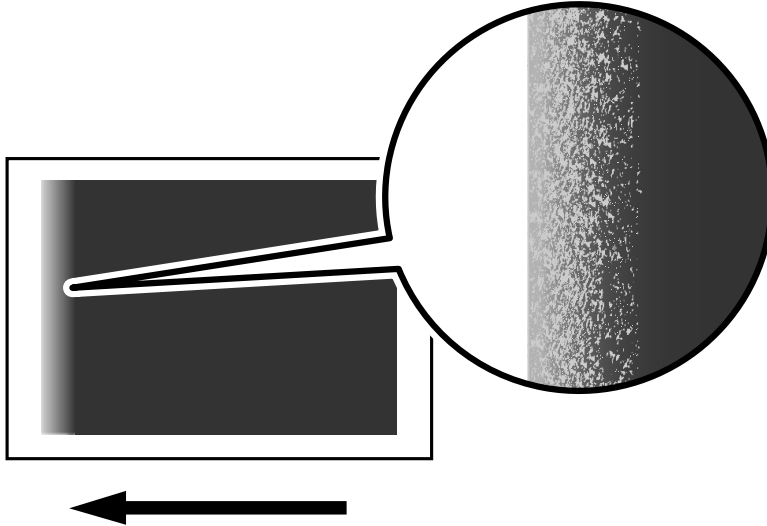
CEZ562

3.4.3 Fainter Leading Edge

The leading edge is fainter.

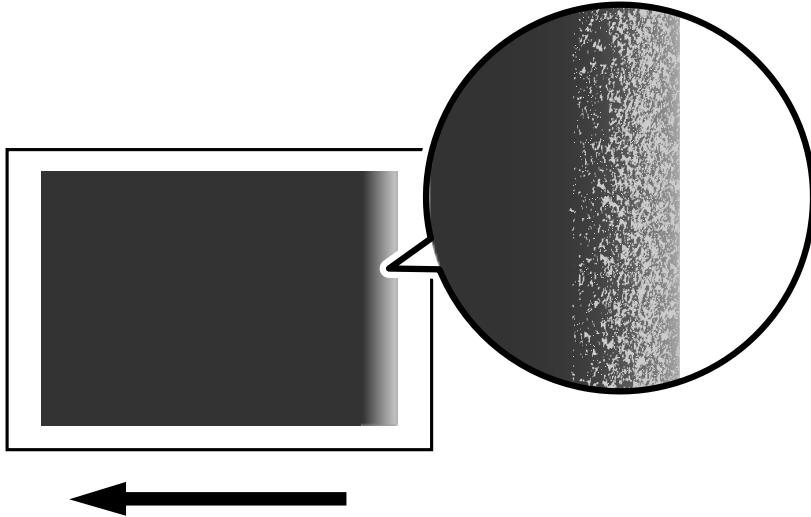
CEZ563

3.4.4 Fainter Trailing Edge

The trailing edge is fainter.

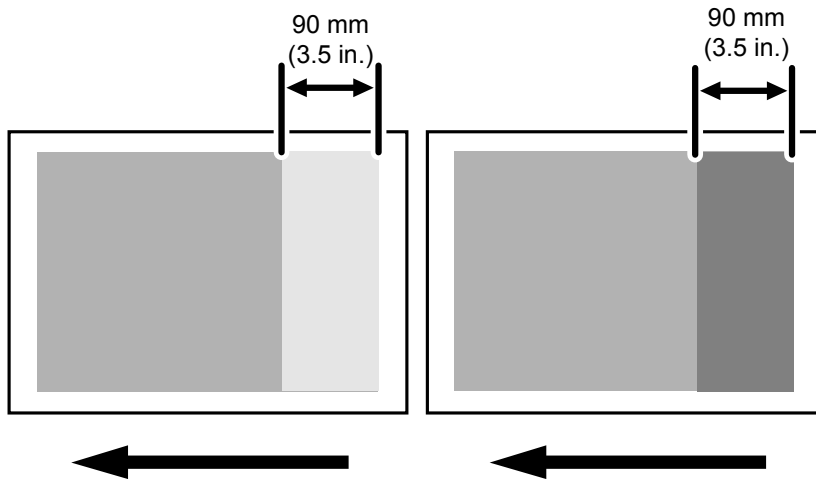
CEZ564

3.4.5 Uneven Density within 90 mm (3.5 in.) of the Trailing Edge

Printing in the area extending approximately 90 mm (3.5 inches) from the trailing edge is fainter or denser when the temperature or humidity is low.

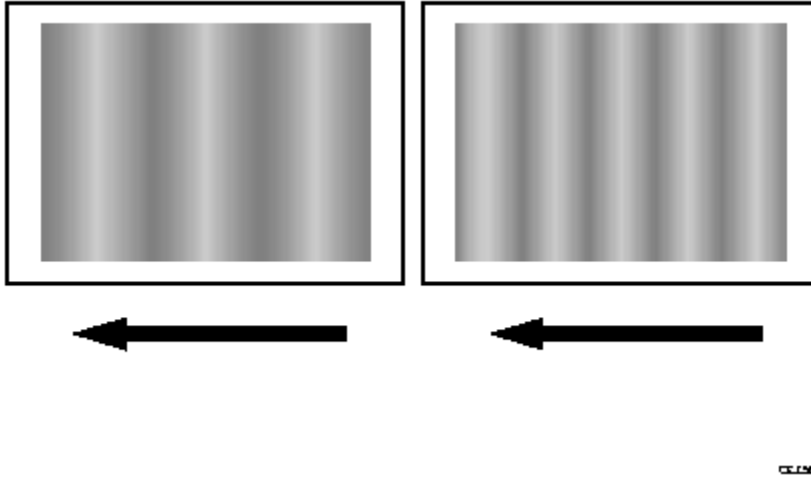
3.4.6 Periodic Density Fluctuation

The vertical density fluctuates periodically.

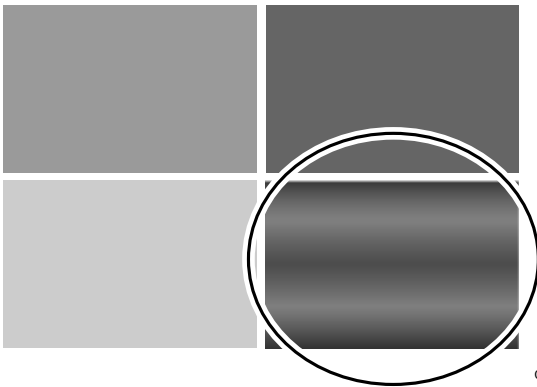
CEZ584

Black is fainter than normal during full colour printing.

Black is fainter

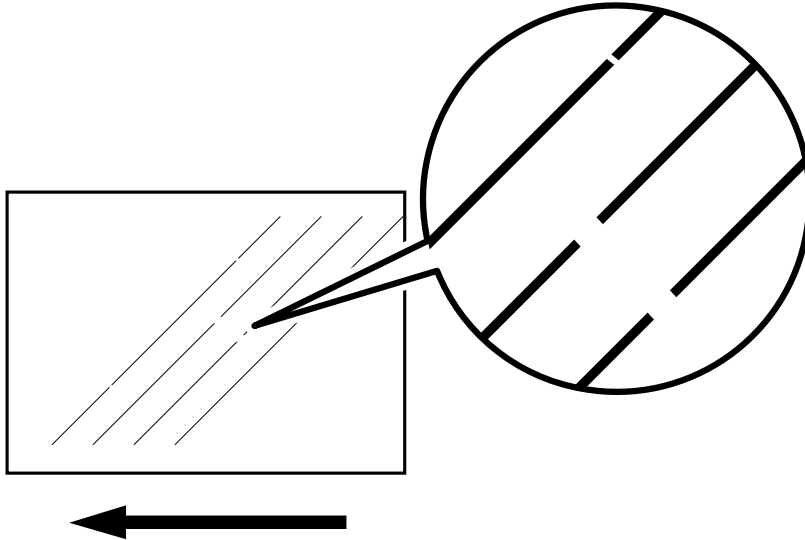
CEZ569

3.4.10 Broken Thin Lines

Thin lines (1 dot lines in 1200 dpi images) break.

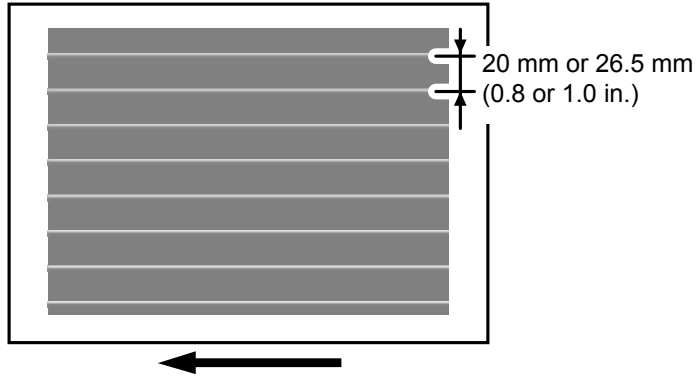
3.5.1 Glossy Lines

Glossy lines appear every 20 or 26.5 mm (0.8 or 1.0 inches).

This may occur if coated or thin paper is used.

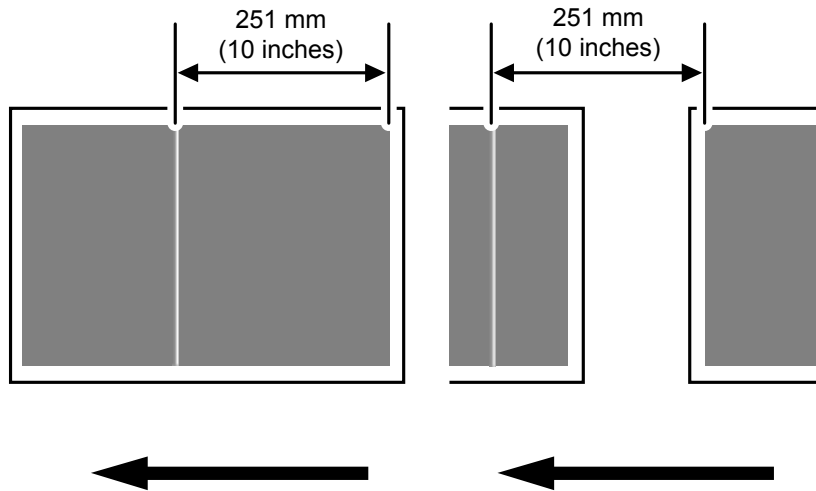
CEZ603

3.5.2 Vertical Glossy Lines

Glossy lines perpendicular to the paper feed direction appear.

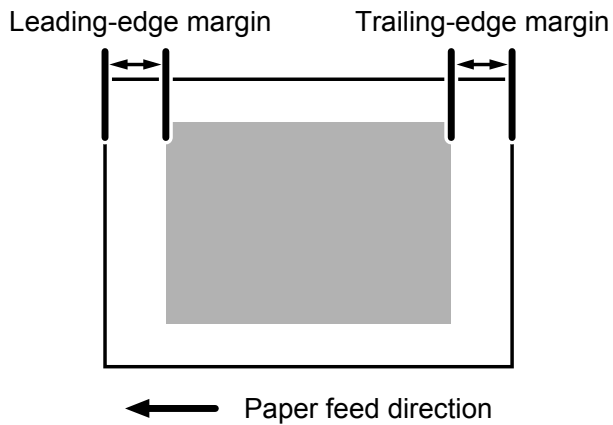
CEZ586

This is likely to occur if:

- Thin or coated paper is used
- A solid image that consumes a lot of toner is printed at the leading edge
- The leading/trailing edge margin is too narrow

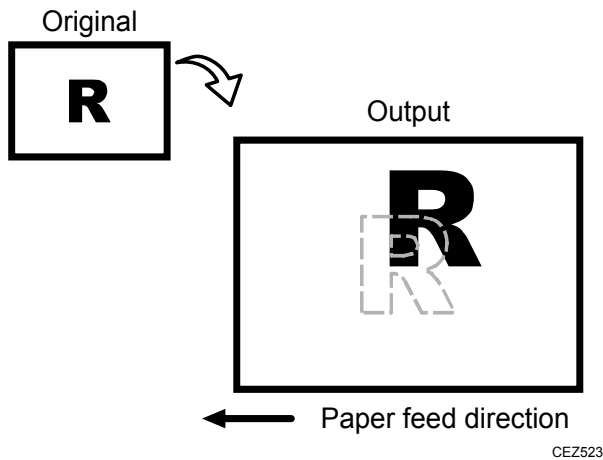
4.8.1 The Image Is Positioned Incorrectly

Depending on the paper thickness, floppiness, edge roughness, and curl, the image may become mispositioned.

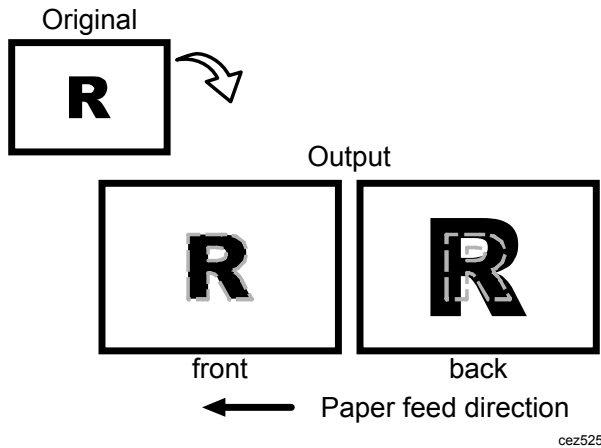
4.8.3 Image Scaling Error on the Side 2 of Paper

An image scaling error on the side 2 of the paper may occur because the paper expands or contracts after the image on the side 1 of the paper has been fused.

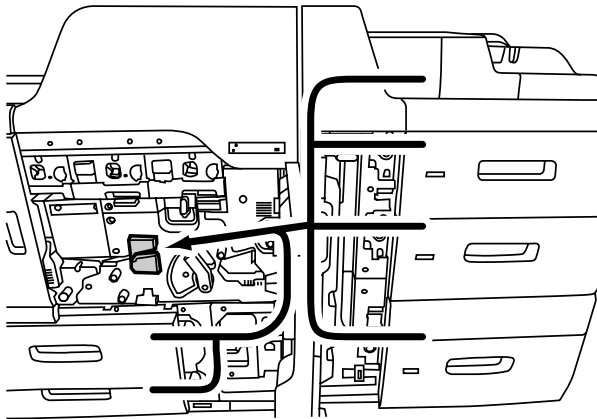
CEZ501

Clean the paper feed path (dust catcher, transfer timing roller, guide board, and paper feed roller) between the paper tray in use and the transfer unit's nip (where the images are transferred from the intermediate transfer belt to the paper).

The paper feed paths between each paper tray and the nip are as follows:

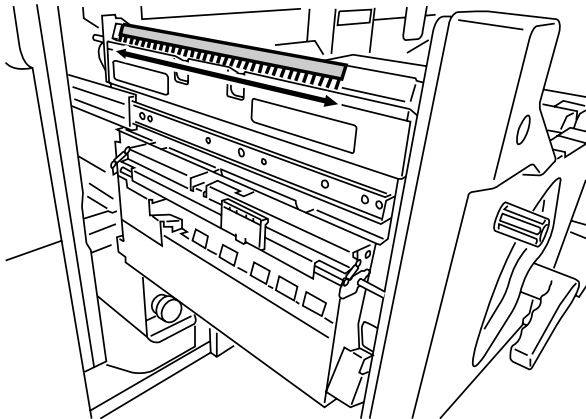
CEZ556

Clean the anti-static brushes with a blower brush.

- The anti-static brush in the exit transport

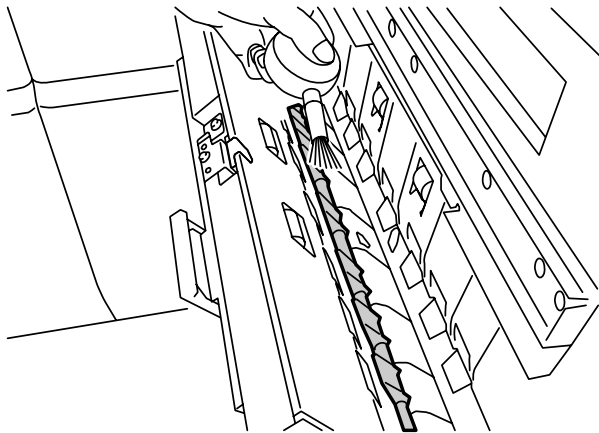
CEZ516

- The anti-static brush in the inverter transport

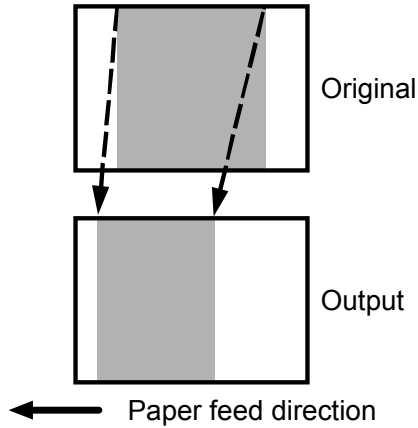
CEZ528

The leading edge margin is too narrow and the image has shrunk lengthwise.

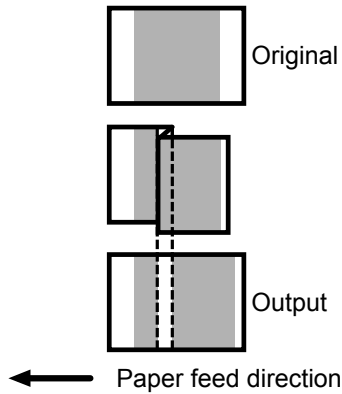
CEZ529

The paper has creased and no print appears where the crease has occurred.

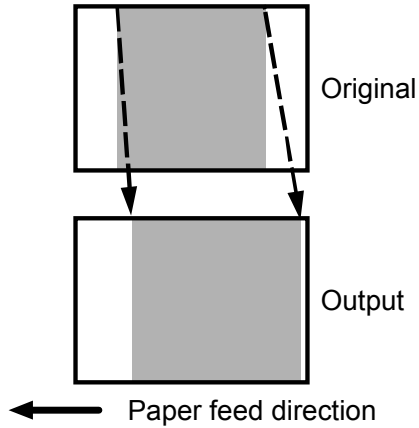
CEZ530

The leading edge margin is too wide and the image has stretched lengthwise.

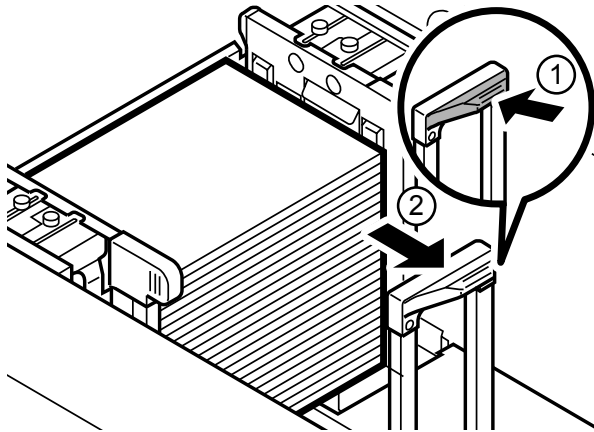
CEZ588

1. Unlock the end fence, and then slide it away from the paper.

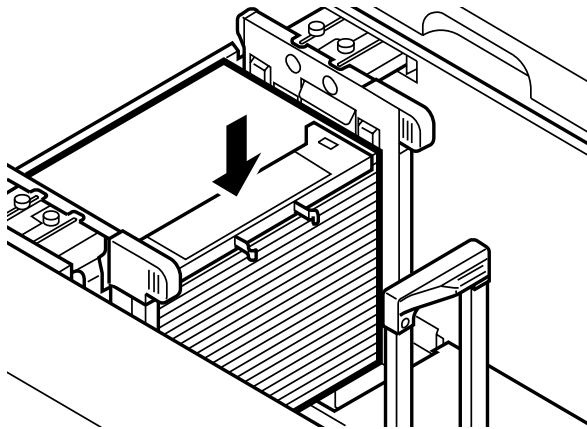
CEZ589

2. Place the tab sheet holder on the paper.

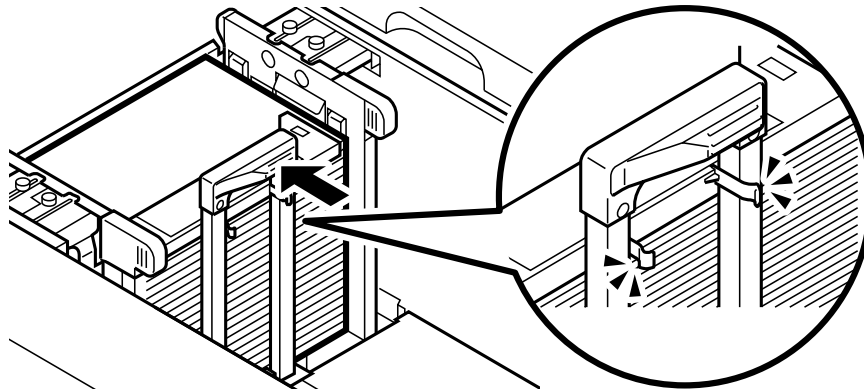
CEZ590

3. Slide the end fence against the paper so that the tab sheet holder's clips pass through the fence and click into place.

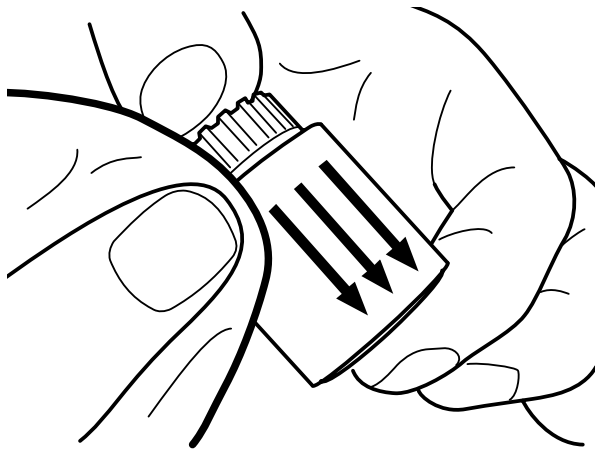
CEZ306

Wipe the entire surface of the paper feed roller lengthwise with a well-wrung-out damp cloth, and then with a dry, unused, lint-free cloth until no moisture remains.

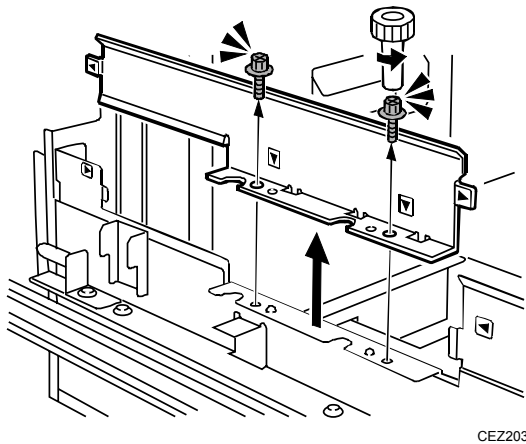
4. Remove the two black screws on the side plate, and then remove the plate.

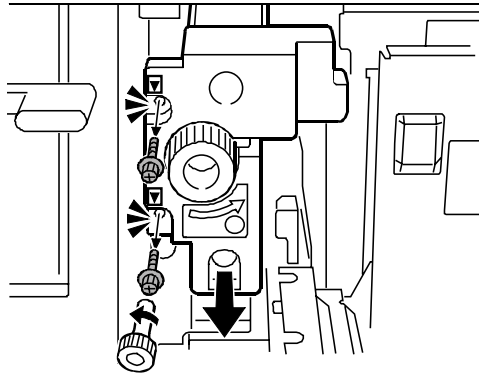
CEZ204

5. Remove the two black screws on the paper feed unit U2, and then pull out the paper feed unit U2 until it stops.

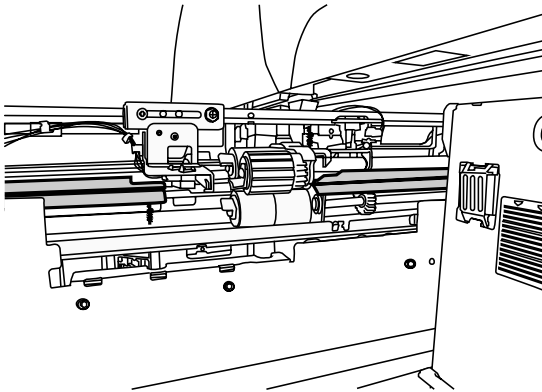
CEZ503

6. Clean the paper feed rollers.
For details about detaching and reattaching the paper feed rollers, see the Replacement Guide.
7. Clean the guide board of the paper feed unit.

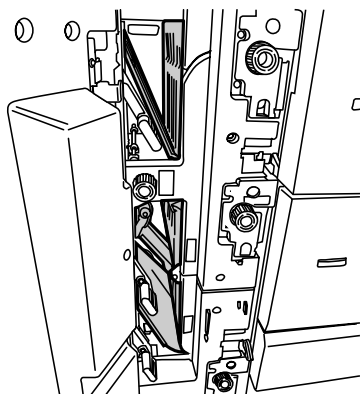
CEZ504

8. Open the guide board (U1), (U3), and (U5), and then clean the guide board interior.

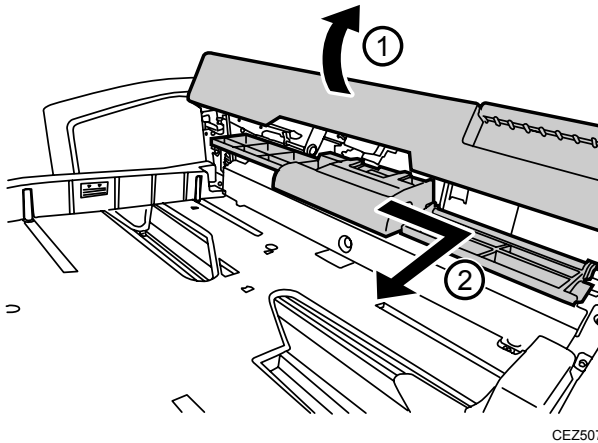
CEZ507

1. Remove the loaded paper.
2. Open the upper cover, and then detach the paper feed unit. Pull it out slightly, release the metal shaft, and then detach it.

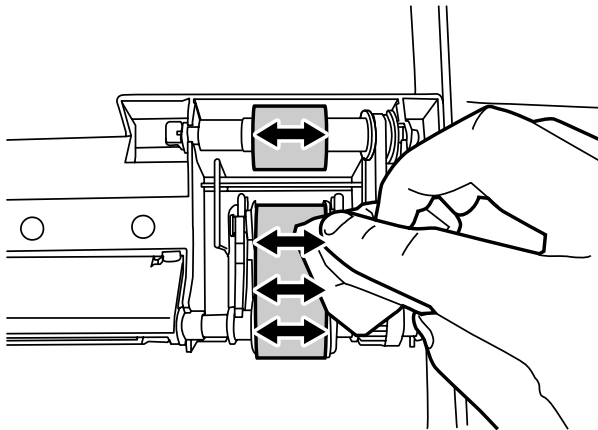
CEZ508

3. Clean the paper feed belt and paper feed rollers in the detached paper feed unit.

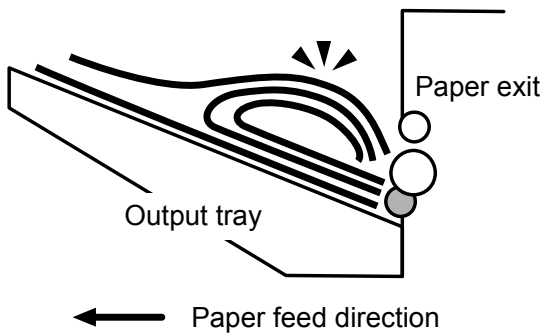
CEZ594

◆ Sheet bending

The leading edge of the delivered sheet bends upward and back.

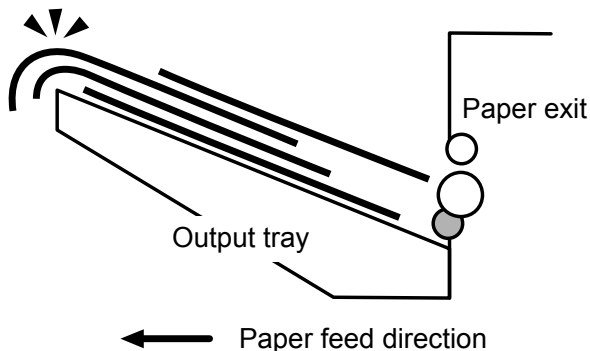
CEZ595

◆ One sheet pushing out another

The sheet being delivered gets stuck to the top sheet of the stack and pushes the top sheet out.

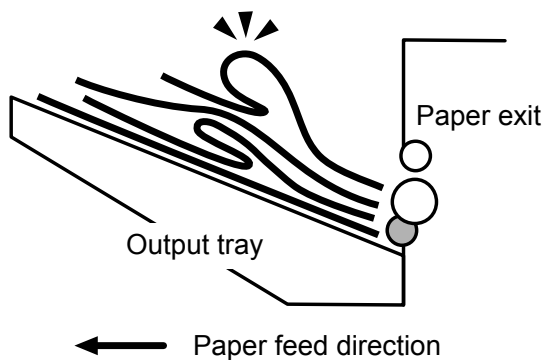
CEZ596

◆ Sheet becoming kinked

The sheet being delivered gets stuck to the top of the stack by its leading edge, arches up, and becomes kinked.

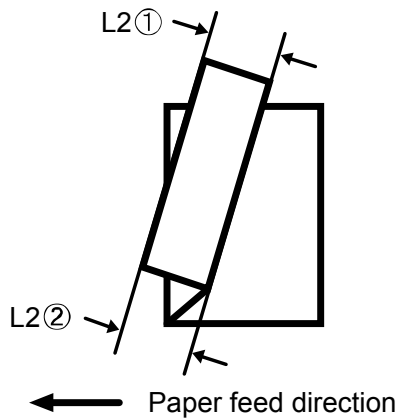
CEZ531

For example, in the following illustration, the dimensional difference between the top (L2[2]) and bottom (L2[1]) edges is the deviation.

<Folding deviation sample of L2 for Z-fold>

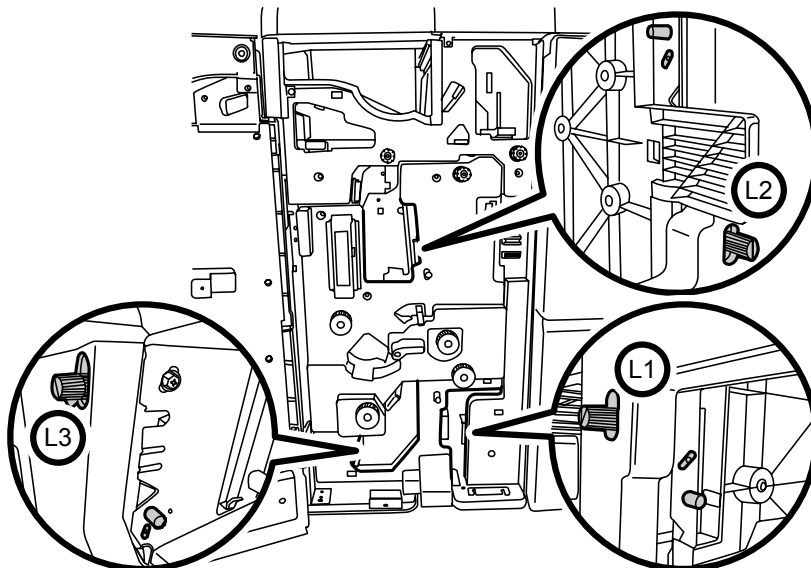
CEZ509

The multi-folding unit has three adjusting screws (L1, L2, and L3) with which to adjust deviation.

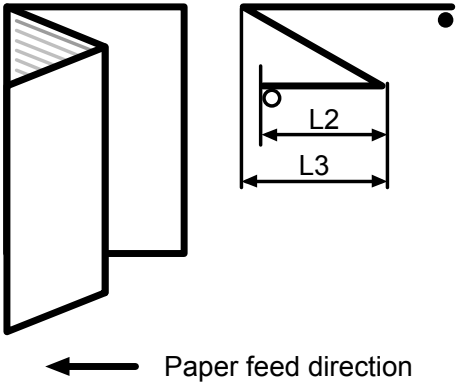
CEZ532

The screws adjust the deviation of the following parts:

◆Z-fold

The ○ mark indicates the leading edge (relative to the paper feed direction), and the ● mark indicates the trailing edge.

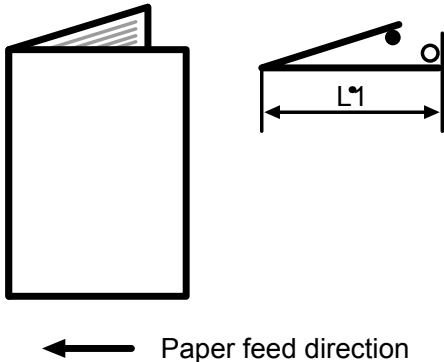
CEZ533

◆Half Fold

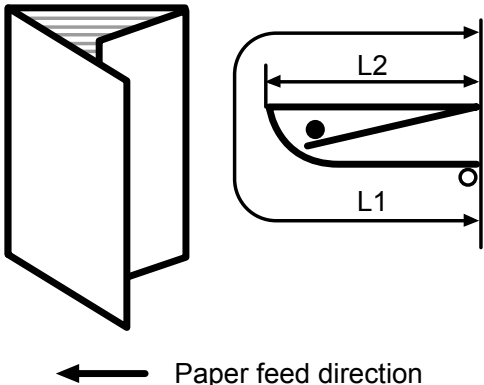
CEZ535

◆Letter Fold-in

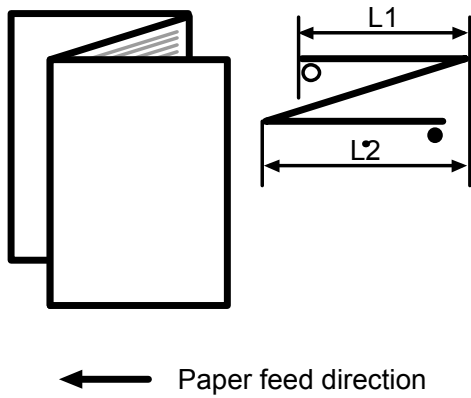
CEZ534

◆ Letter Fold-out

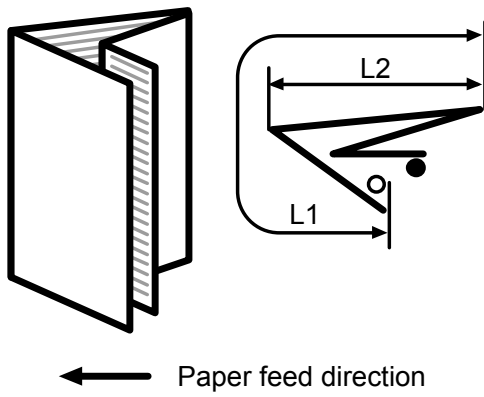
CEZ536

◆ Double Parallel

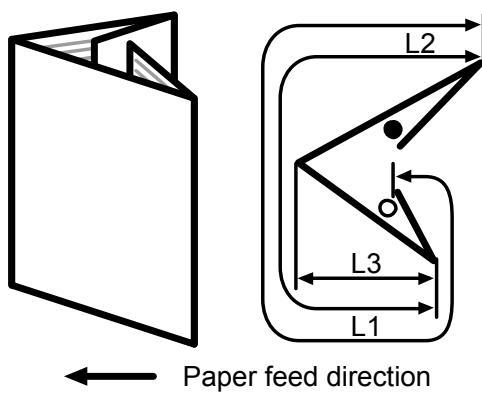
CEZ537

◆ Gate Fold

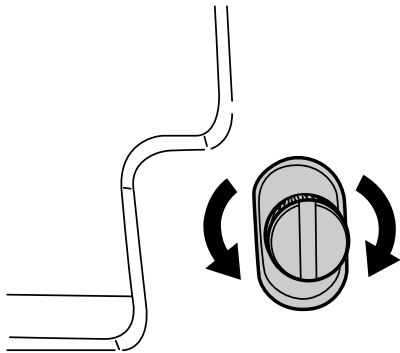
CEZ510

1. Open the front cover of the multi-folding unit.
2. Remove the mounting screw.
If the mounting screw is attached to the adjusting screw hole, unfasten it.
3. Turn the adjusting screw to adjust the deviation.
 - To increase the length at the bottom part of paper, turn the screw clockwise.
 - To decrease the length at the bottom part of paper, turn the screw counterclockwise.

4. Attach the mounting screw to fasten the adjusting screw.
If the mounting screw is attached to the adjusting screw hole, fasten it.
5. Close the front cover of the multi-folding unit.

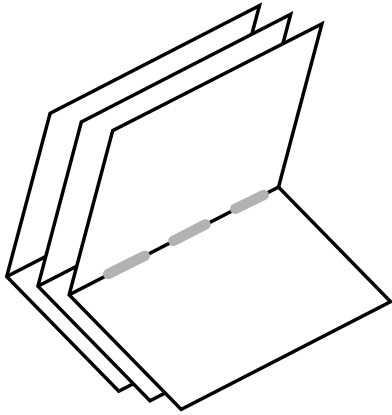
CEZ571

If multi-sheet folding is performed after a large number of z-folds have been performed, the tip of the blade used for the multi-sheet folding may be soiled, in turn soiling the paper.

This will produce soiling 1-3 cm (0.4-1.2 inches) in width (equal to the width of the blade) in the fold of the center sheet.

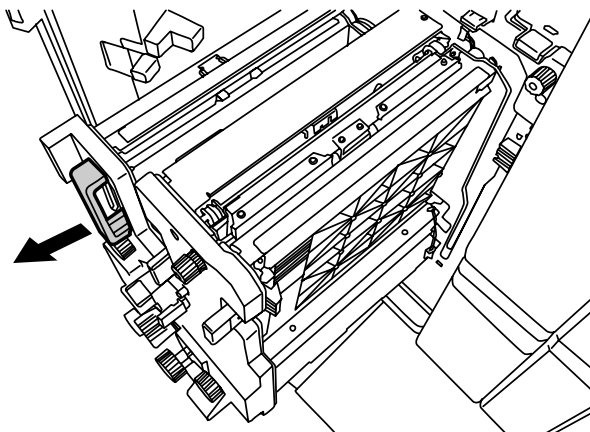
CEZ511

1. Open the front cover of the multi-folding unit.
2. Pull the multi-folding unit out.

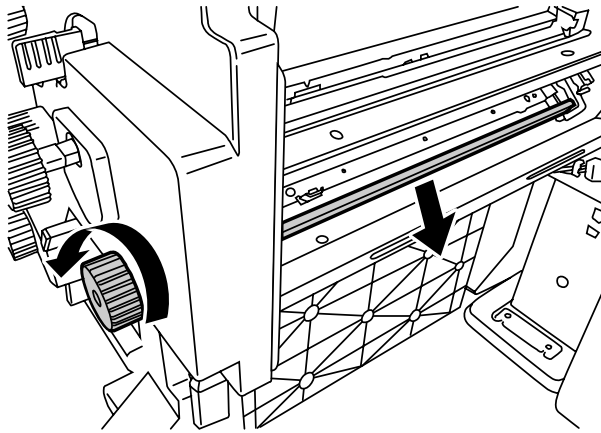
CEZ512

3. Turn the N11 dial counterclockwise until the blade appears.
The blade is located in the right part of the multi-folding unit.

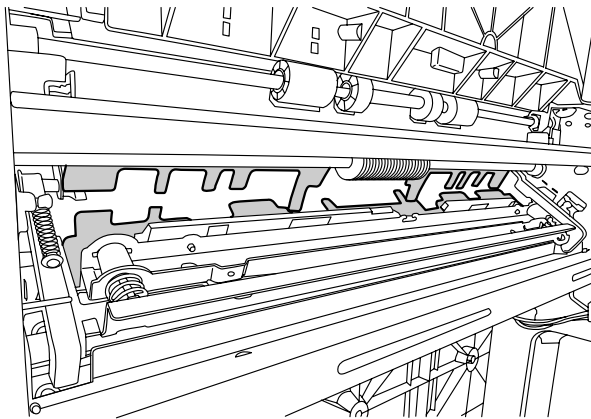
CEZ513

4. Wipe the tip and top of the blade with a soft dry cloth.
Be careful not to damage the blade.

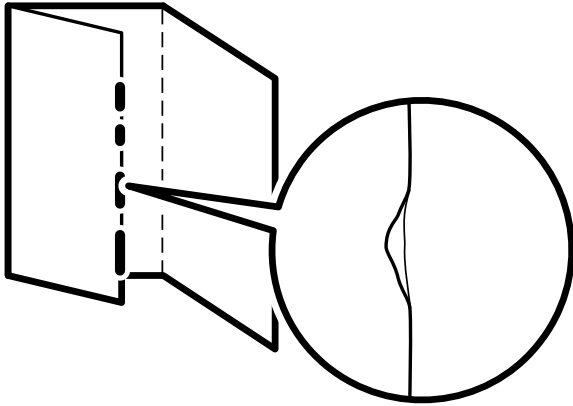
CEZ592

When letter folding multiple sheets, the edge of the inner flap may become bent.

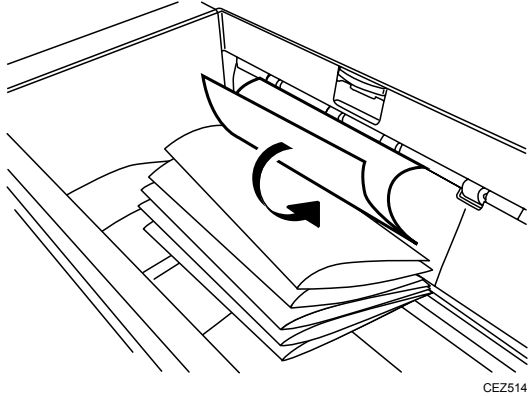
- Thick, relatively stiff paper is used.

As a bundle is delivered, its folded edge droops and catches on the stacked bundles, causing the delivered bundle to flip over.

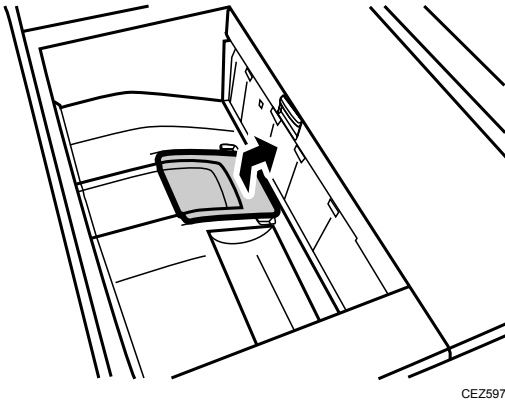
Use the Z-fold support tray for multi-folding unit.

This will reduce the angle of stacked bundles and prevent bundles flipping over as they are delivered.

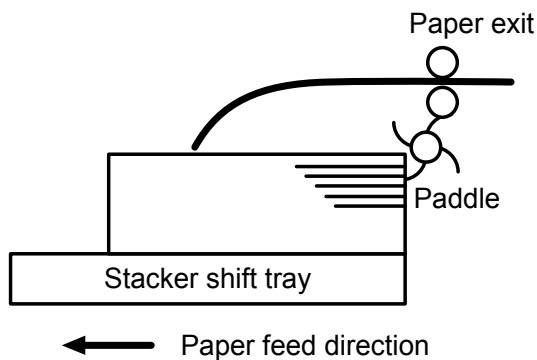
CEZ573

(1) Downward curled paper is delivered to the stacker tray.

Sheets with downward curls rub too much at their leading edges. This can cause a sheet to stop short with its trailing edge still in the paper exit.

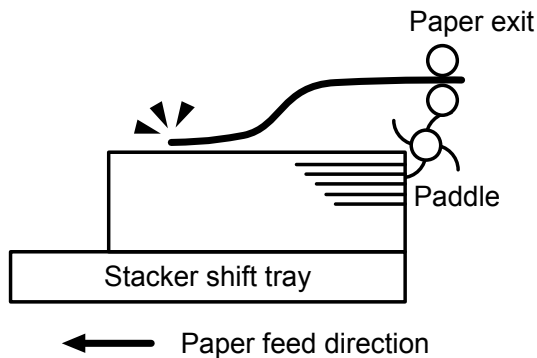
CEZ574

(2) The leading edge of the sheet being delivered rubs against the top sheet of the stack, there being no air gap between the sheets, and the sheet being delivered gets stuck.

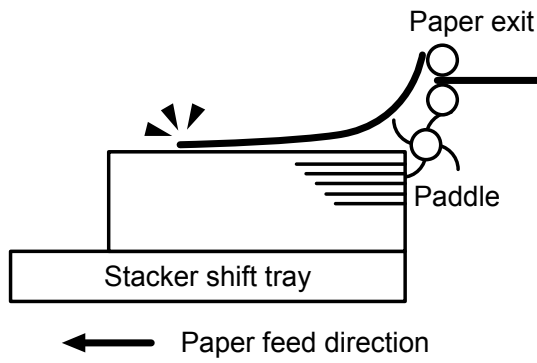
CEZ575

(3) The trailing edge of the sheet being delivered is left in the paper exit.

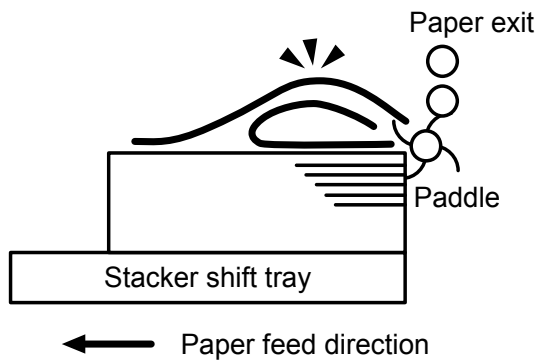
CEZ576

(4) The next sheet to be delivered slips under the sheet still in the paper exit and bends back.

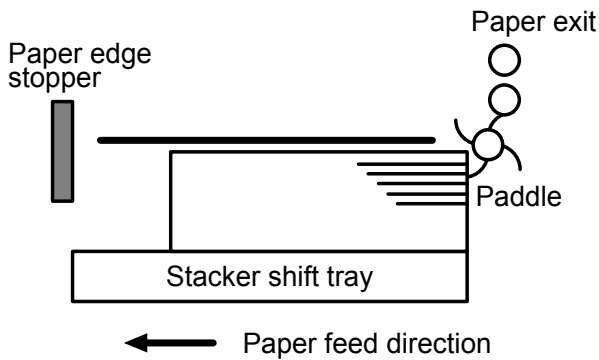
CEZ577

(1) An uncurled sheet is delivered to the stacker shift tray.

When delivering sheets to the stacker tray, because of the friction between the sheets, the paddle fails to drag the trailing edge back into the front guide, resulting in misalignment.

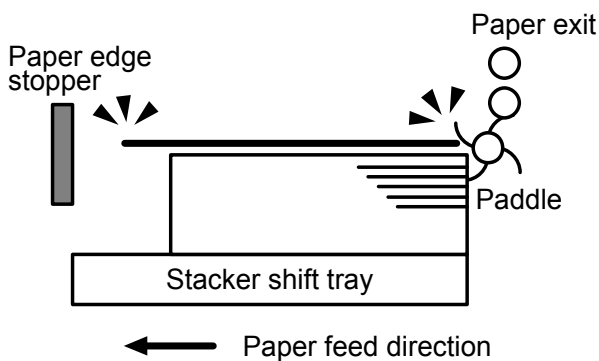
CEZ578

(2) The friction at the trailing edge is too great for the paddle to drag the sheet back and align the edges of the sheet with the edges of the stack.

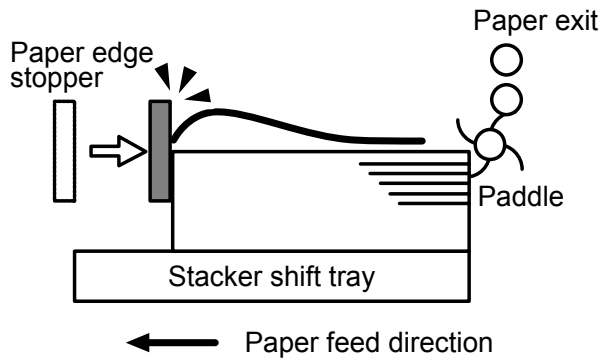
CEZ579

- (3) The paper edge stopper fails to push back the protruding leading edge and align the sheet that way.

The paper edge stopper also fails to push back the protruding leading edge.
