708P91368
September 2017

Xerox® AltaLink® B8090 Family Multifunction Printer Service Manual

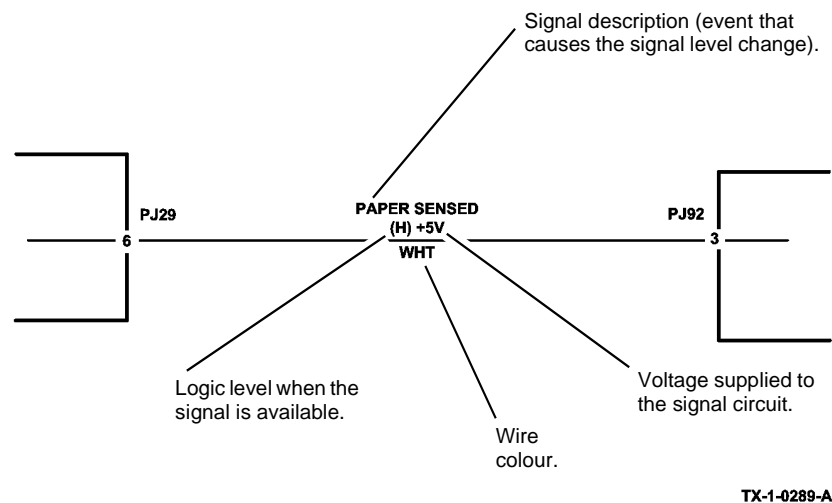
Figure 1 Signal Nomenclature

[Figure 1](#) shows the signal nomenclature used in this manual.

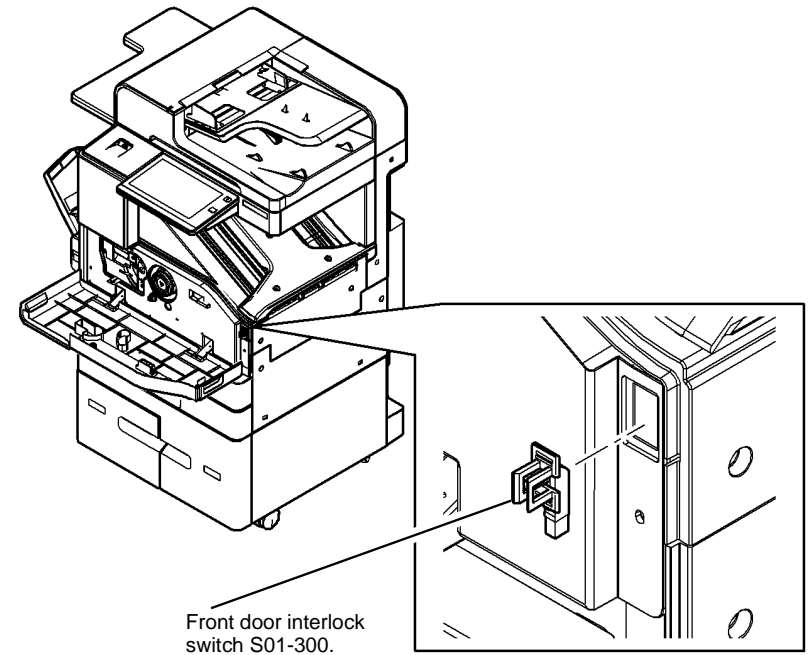
Figure 1 Component location

- The switch actuating flag on the front door for damage.
- The front door assembly, [PL 28.11 Item 1](#) is not distorted or damaged.
- The magnet, [PL 28.11 Item 3](#) is not damaged or missing.

If necessary install a new front door assembly, [PL 28.11 Item 1](#).

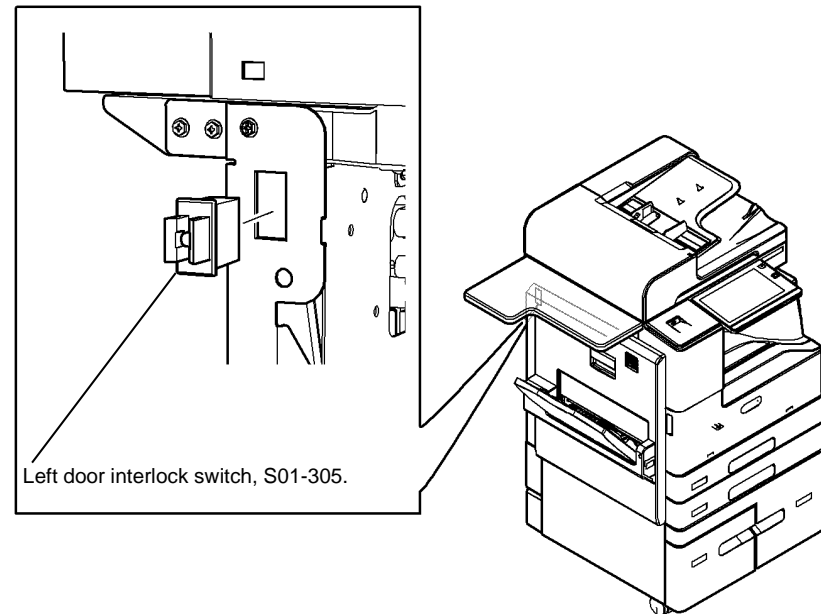
Figure 1 component location

Check that the left door assembly, PL 80.10 Item 1 closes correctly. If not, check the components that follow:

- Rear latch cam, PL 80.11 Item 11.
- Rear latch, PL 80.11 Item 10.
- Front latch cam, PL 80.11 Item 5.
- Front latch, PL 80.11 Item 4.
- Damper spring (2), PL 80.11 Item 2.
- Damper cable (2), PL 80.11 Item 3.

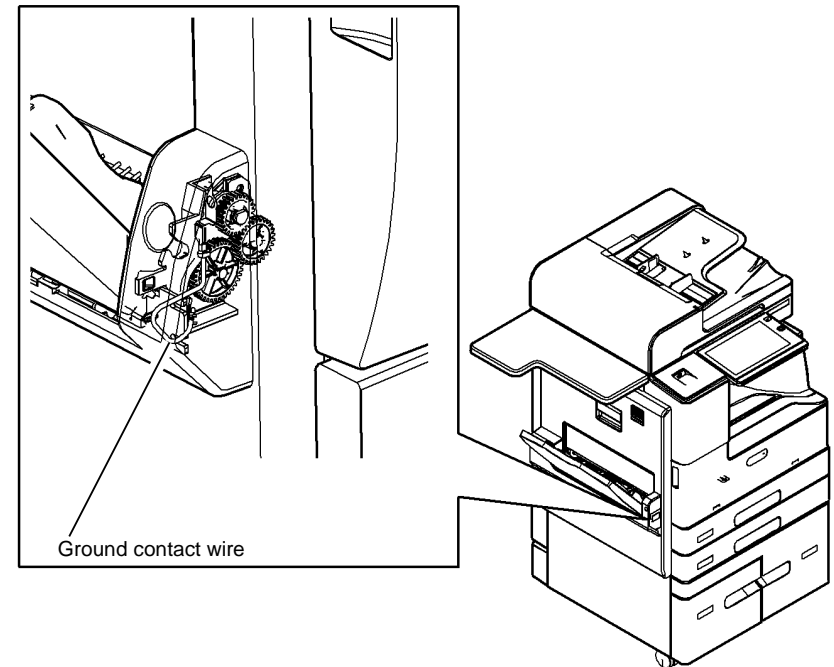
Figure 1 Bypass ground connections

1. Remove the feed roll assembly, REP 80.15.
2. Remove the ground wire, Figure 1 and clean the terminals at both ends of the wire.
3. Clean the bearings, PL 70.35 Item 10 and the parts of the feed roll shaft where the bearings locate.
4. Reassemble the bypass tray assembly

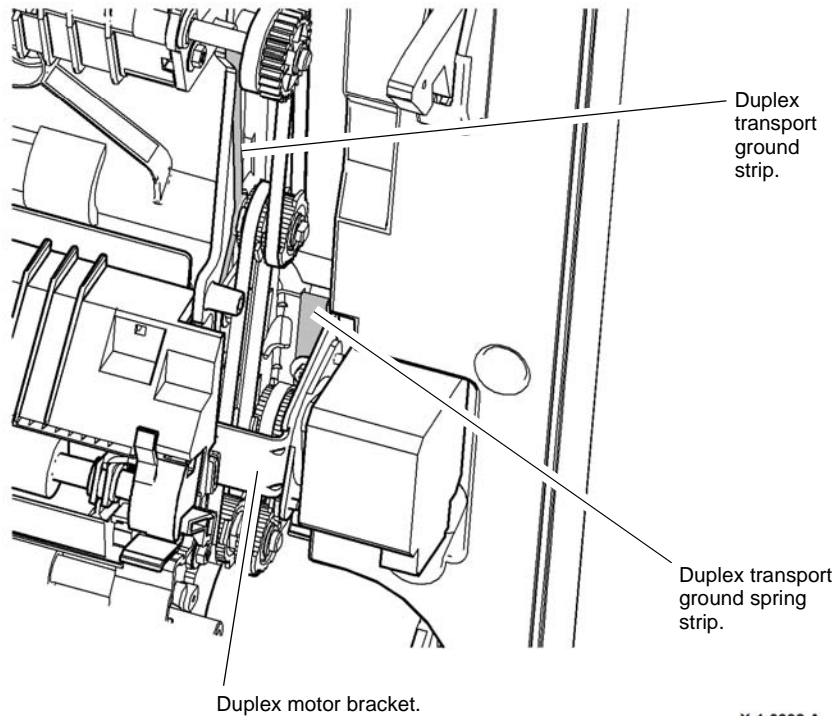
Figure 2 Duplex transport ground

Refer to [Figure 2](#). Check the tightness of the screw holding the ground spring strip to the duplex motor bracket. Check for continuity of less than 10 ohms between the duplex motor bracket and the machine frame. If necessary remove the ground spring strip, clean the contact faces and re-assemble, to improve continuity.

Refer to [Figure 2](#). Check for continuity of less than 10 ohms between the duplex transport ground strip and the machine frame. If necessary remove the duplex transport ground strip, clean the contact faces and re-assemble, to improve continuity.

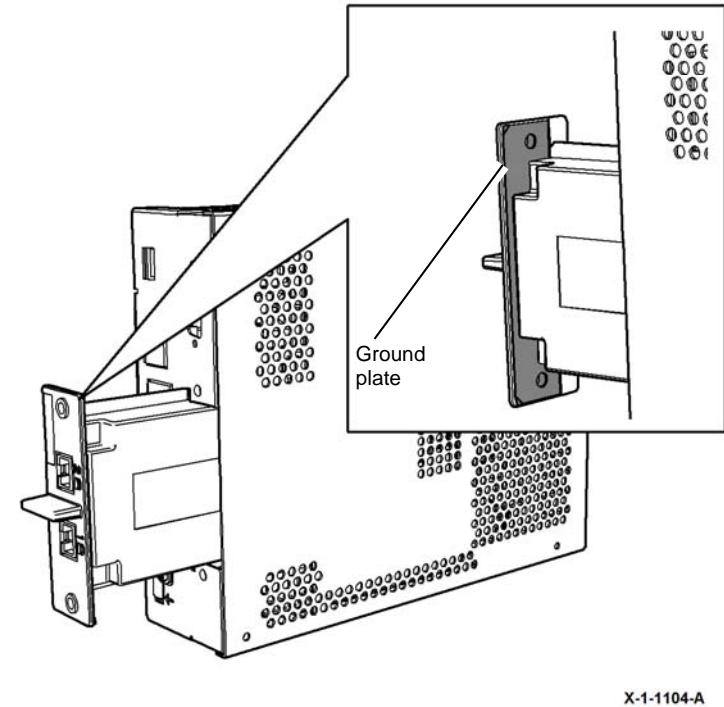
Figure 3 Fax module ground

Refer to [Figure 3](#). Ensure the face of the Fax module ground plate and the mounting area of the SBC cage are clean.

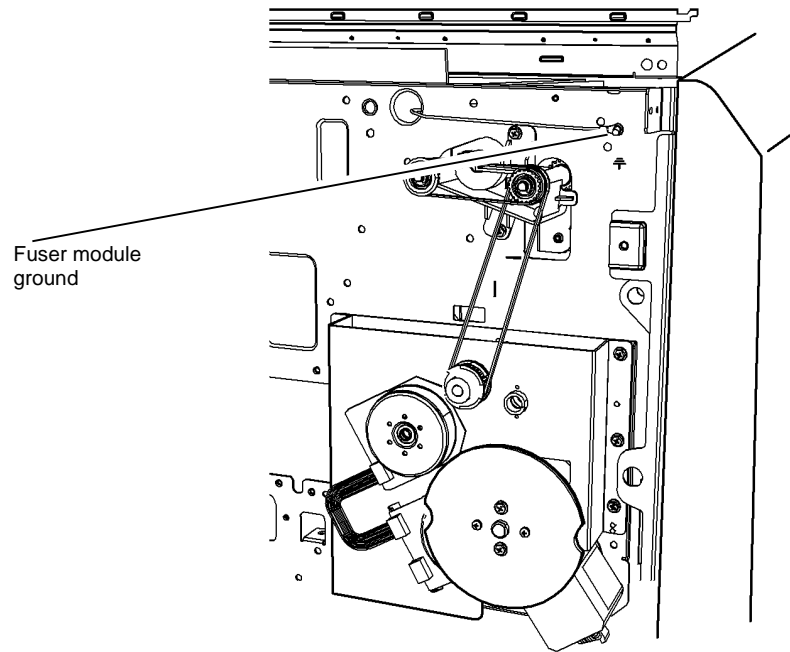
Figure 4 Fuser module ground

Refer to [Figure 4](#). Perform the steps that follow:

- To improve continuity, disconnect the fuser module ground terminal, clean the contact faces and re-assemble.
- Remove the fuser. Check the drawer connector contacts are clean and undamaged. If necessary install new components.

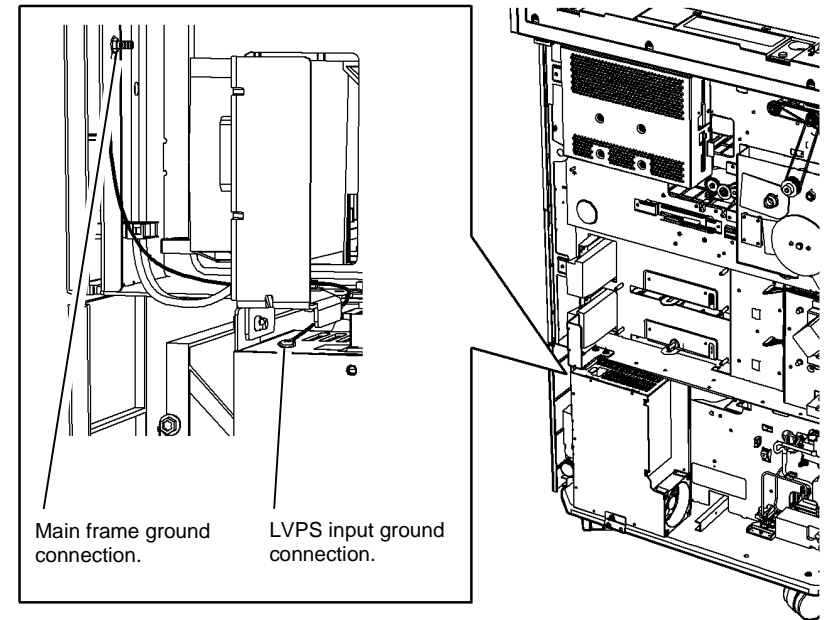
Figure 5 Component location

Refer to [Figure 5](#), check for continuity of less than 1 ohm between the LVPS input ground connection and the main frame ground. Also check for a continuity of less than 1 ohm between the scanner module ground connection and the main frame ground. Check that the hardware is tight and the harness crimping is good. To improve continuity, disconnect the terminals, clean the contact faces then re-assemble.

Refer to [Figure 8](#). Open the left door. Rotate the transport rolls by hand and check for continuity of less than 10k ohms between the tray 1 and tray 2 transport roll shafts and the main frame ground connection, [Figure 5](#). To improve continuity for the tray 1 and tray 2 transport roll shafts, remove, clean and re-install the shaft and bearings, [REP 80.10](#).

Remove the tray 4 front cover, [PL 70.26 Item 5](#) (4 screws). Refer to [Figure 18](#). With tray 4 closed, check for continuity of less than 10k ohms between the tray 4 takeaway roll shaft and the main frame ground connection, also between the HCF transport roll shaft and the main frame ground connection, [Figure 5](#).

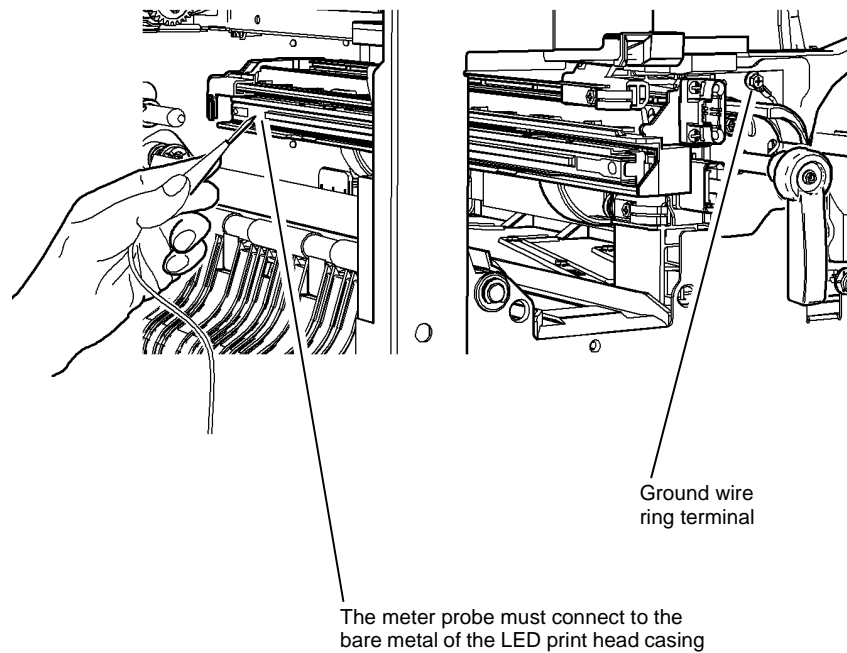
Figure 6 LPH ground connection

Check for continuity of less than 10 ohms between the LED print head casing, [Figure 6](#) and the main frame ground connection.

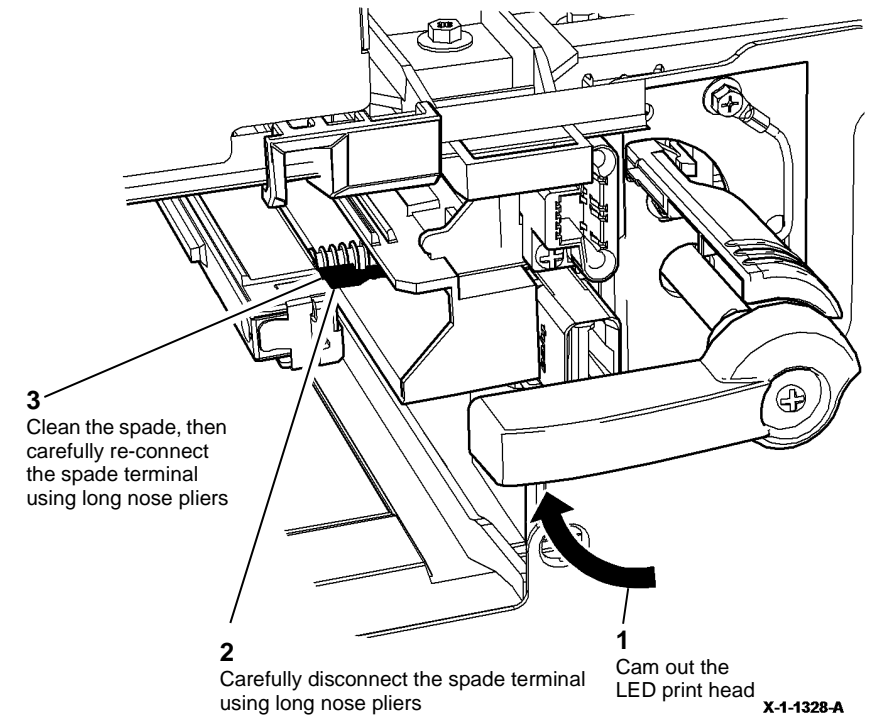
Figure 7 LPH ground spade connection

1. Remove the LED print head module, [REP 60.12](#).
2. Clean the contact faces of the ground wire ring terminal.
3. [Figure 7](#), clean the contact faces of the LPH ground spade connector.

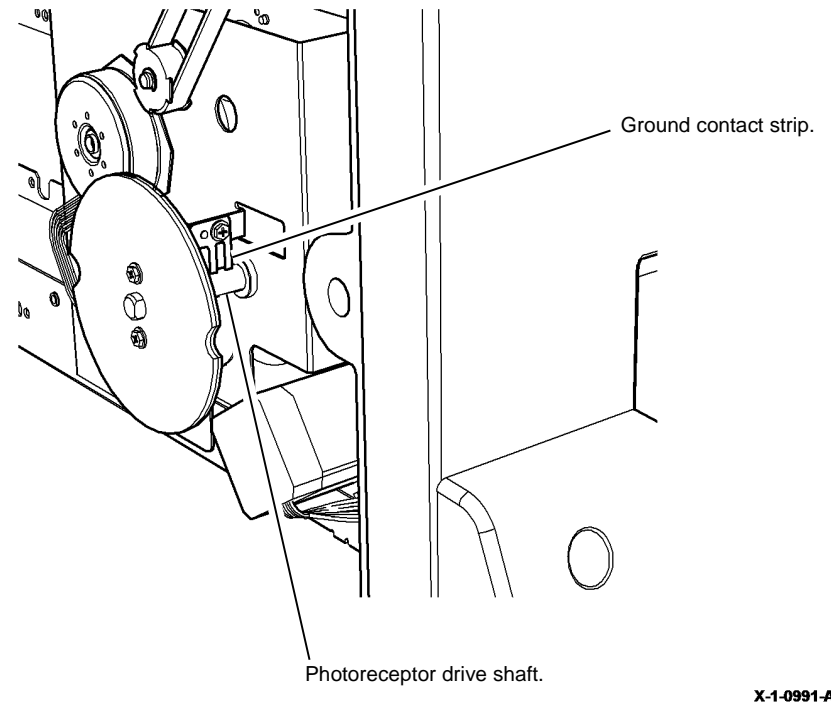
Figure 9 Print cartridge ground

Refer to [Figure 9](#). Ensure the machine is switched off, [GP 14](#). Check for continuity of less than 10 ohms between the machine frame and photoreceptor drive shaft. To improve continuity, remove the ground contact strip, [Figure 9](#) and clean the contact areas of the strip, frame bracket and drive shaft, then re-assemble and test.

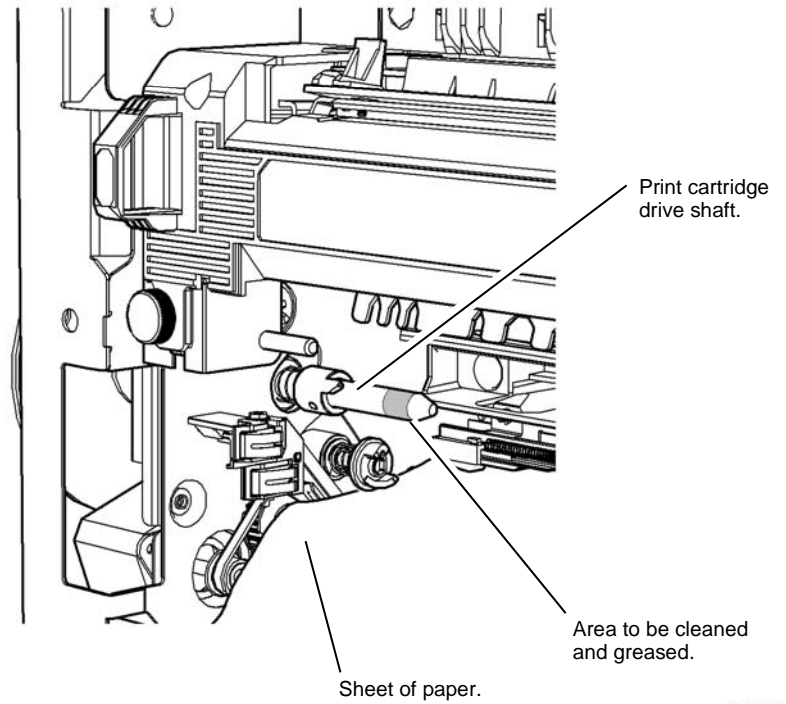
Figure 11 Print cartridge drive shaft

1. Remove the print cartridge, [PL 90.17 Item 9](#).
2. Put a sheet of paper beneath the print cartridge drive shaft, [Figure 11](#).

3. Use an abrasive cloth, [PL 26.10 Item 1](#) to clean the front end of the print cartridge drive shaft. Lubricate the cleaned area with high conductive grease, [PL 26.11 Item 9](#).
4. Re-assemble and test. If necessary, install a new print cartridge, [PL 90.17 Item 9](#).

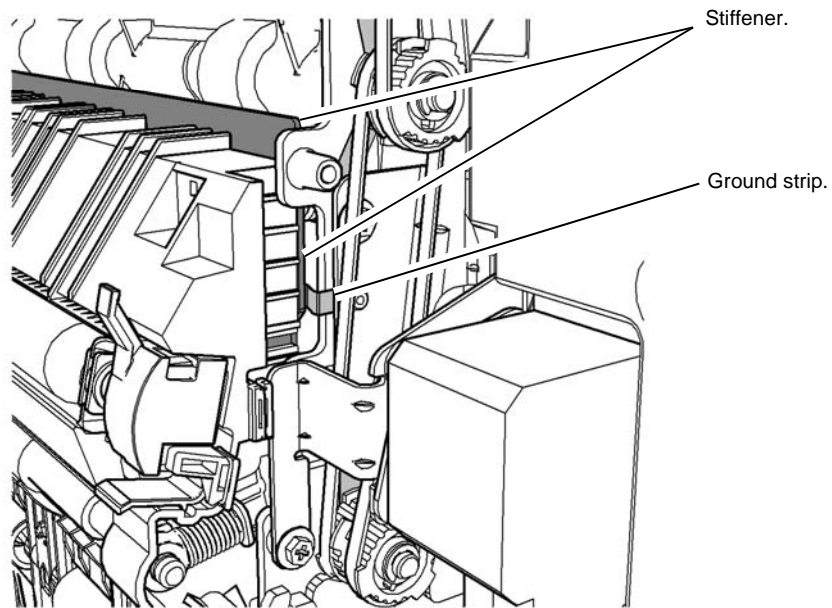
Figure 12 Stiffener ground

Refer to [Figure 12](#). Check for continuity of less than 10 ohms between the stiffener and the ground strip, [PL 80.22 Item 18](#). If necessary remove the stiffener (4 screws), clean the contact faces and re-assemble, to improve continuity.

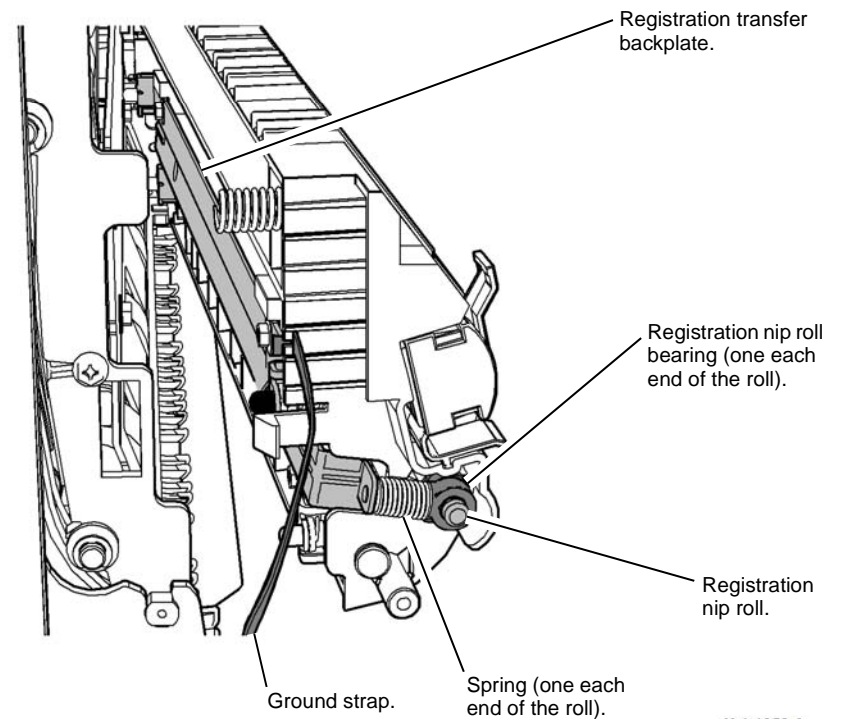
Figure 13 Transfer ground

Refer to [Figure 13](#). Check for continuity of less than 10 ohms between the registration transfer backplate and the springs, [PL 80.15 Item 10](#). If necessary remove the springs, clean the contact faces and re-assemble, to improve continuity.

Refer to [Figure 13](#). Check for continuity of less than 2k ohms between the springs and the registration nip roll, [PL 80.15 Item 4](#). If necessary remove the springs, registration nip roll and registration nip roll bearings. Clean the contact faces and re-assemble, to improve continuity.

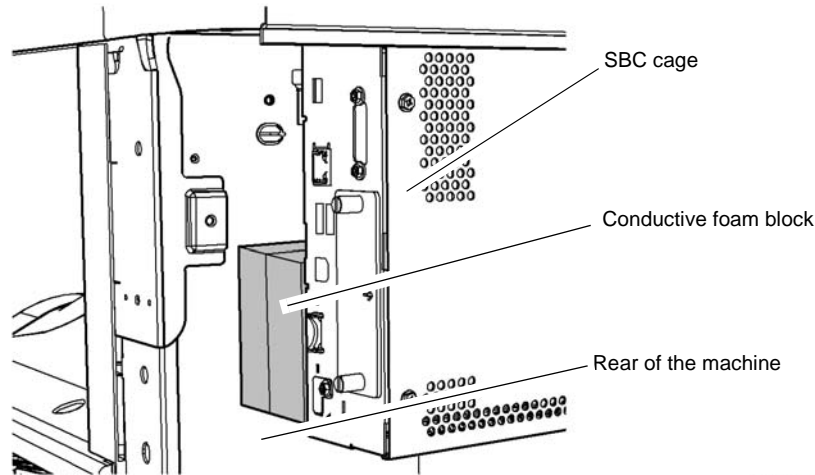
Figure 14 SBC Cage

Refer to [Figure 14](#). The conductive foam blocks are installed only on european 50Hz machines for the protection of the SBC PWB. Ensure the the blocks are in good condition and making secure contact between the rear of the machine and the SBC cage. If necessary install a new conductive foam block, [PL 3.22 Item 26](#).

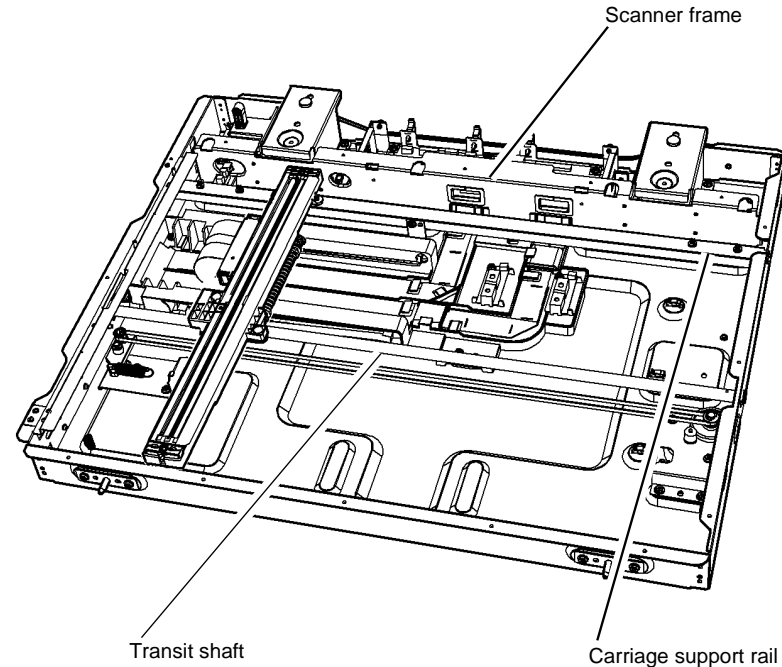
Figure 15 Scanner ground connections

Refer to [Figure 15](#). Check the connections that follow:

- For continuity of less than 10 ohms between the scanner frame and the transit shaft. To improve continuity disassemble the parts, clean the contact faces and re-assemble.
- For continuity of less than 10 ohms between the scanner frame and the carriage support rail. To improve continuity disassemble the parts, clean the contact faces and re-assemble.
- The cleanliness of the foam pad between the scan carriage and the carriage support rail. If necessary clean the pad using film remover, [PL 26.10 Item 4](#).

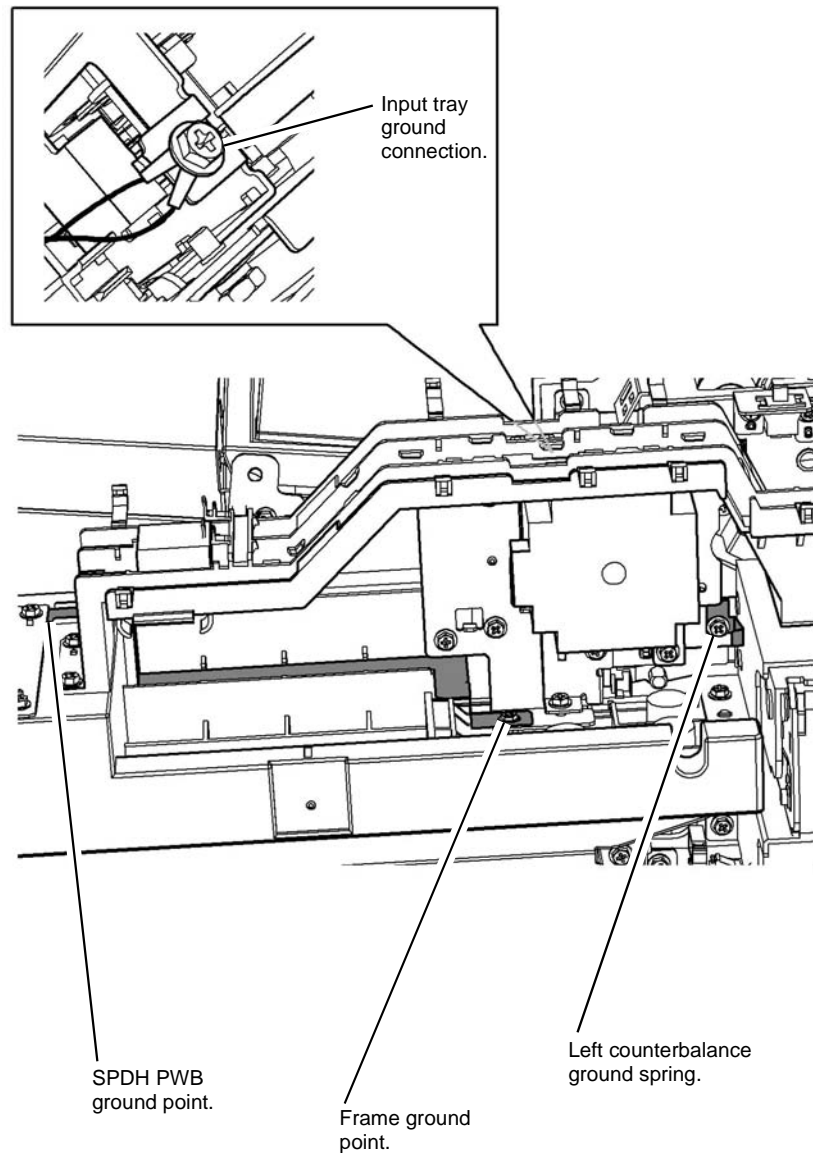
Figure 17 SPDH ground connections 2

- Remove the input tray upper assembly, [REP 5.4](#), but do not disconnect the harness. Check for continuity between the ground point on the sensor mounting bracket, [PL 5.30 Item 12](#) and the input tray ground connection indicated in [Figure 17](#). To improve continuity disconnect, clean and reassemble the connections.
- Check for continuity between the frame ground point and the SPDH PWB ground point [Figure 17](#). To improve continuity disconnect, clean and reassemble the connections.

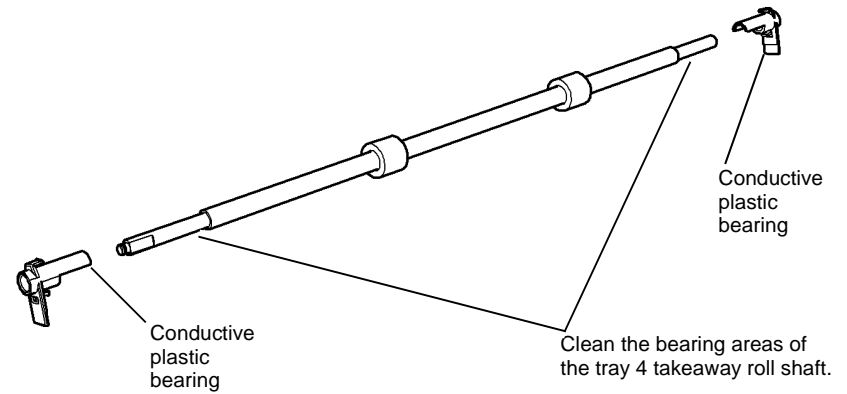
Figure 19 Component cleaning

1. If necessary, open the tray then rotate the shafts. Close the tray and repeat the measurements.
2. To improve continuity, remove the tray 4 takeaway roll, [REP 80.26](#). Refer to [Figure 19](#). Clean the conductive plastic bearings and shaft. Then install the removed components.

Clean inside and outside of the conductive plastic bearings.

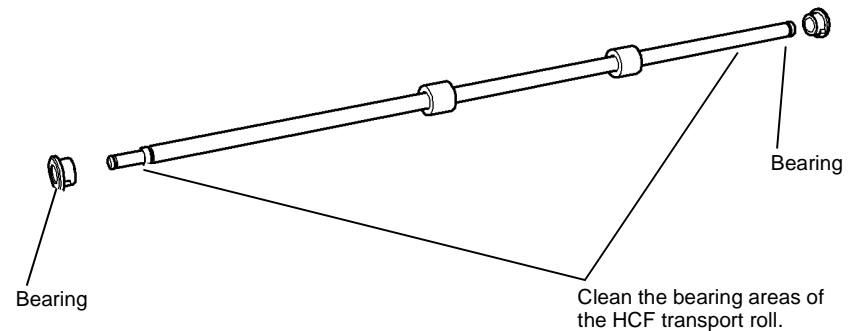
Figure 20 Component cleaning

3. To improve continuity, remove the HCF transport roll and bearings, [REP 80.27](#). Refer to [Figure 20](#). Clean the bearings and shaft. Then install the removed components.

Clean inside and outside of the conductive plastic bearings.

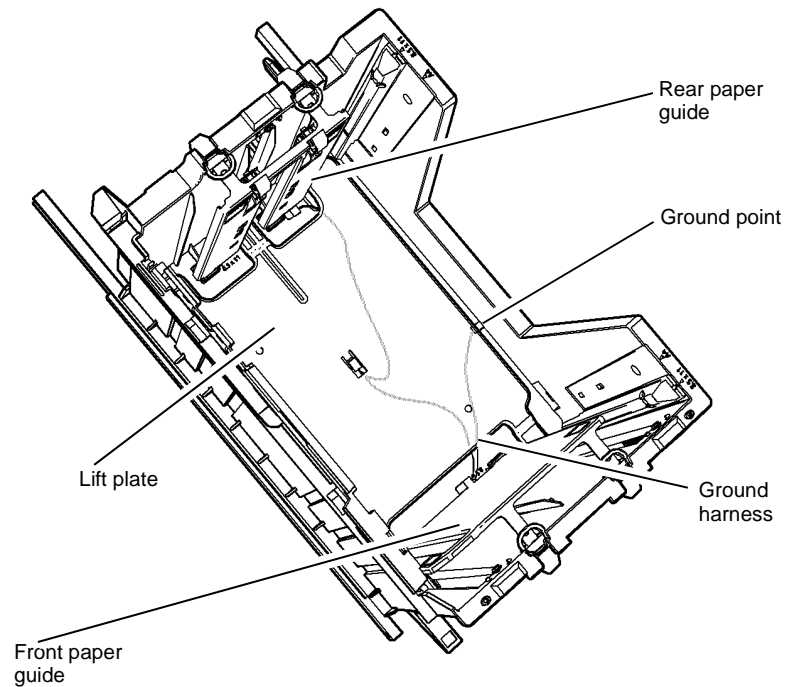
Figure 21 Tray 4 grounding

4. Empty tray 4 of paper. Refer to [Figure 21](#). Check for continuity of less than 10k ohms between the ground point and the points that follow:
- Lift plate.
 - Front paper guide
 - Rear paper guide.

To improve continuity, disconnect and clean the ground harness connectors, then re-connect.

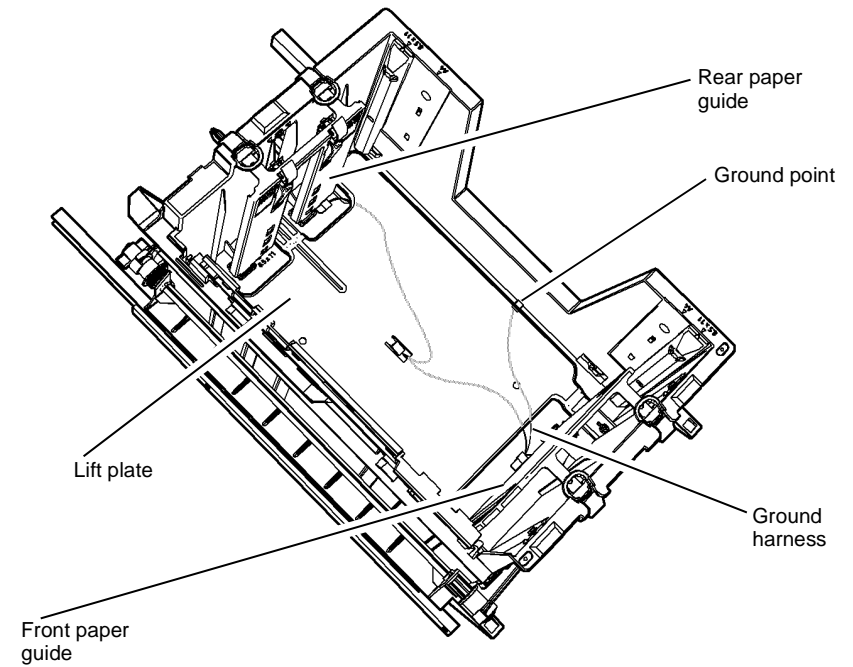
Figure 22 Tray 3 grounding

5. Empty tray 3 of paper. Refer to [Figure 22](#). Check for continuity of less than 10k ohms between the ground point and the points that follow:
- Lift plate.
 - Front paper guide
 - Rear paper guide.

To improve continuity, disconnect and clean the ground harness connectors, then re-connect.

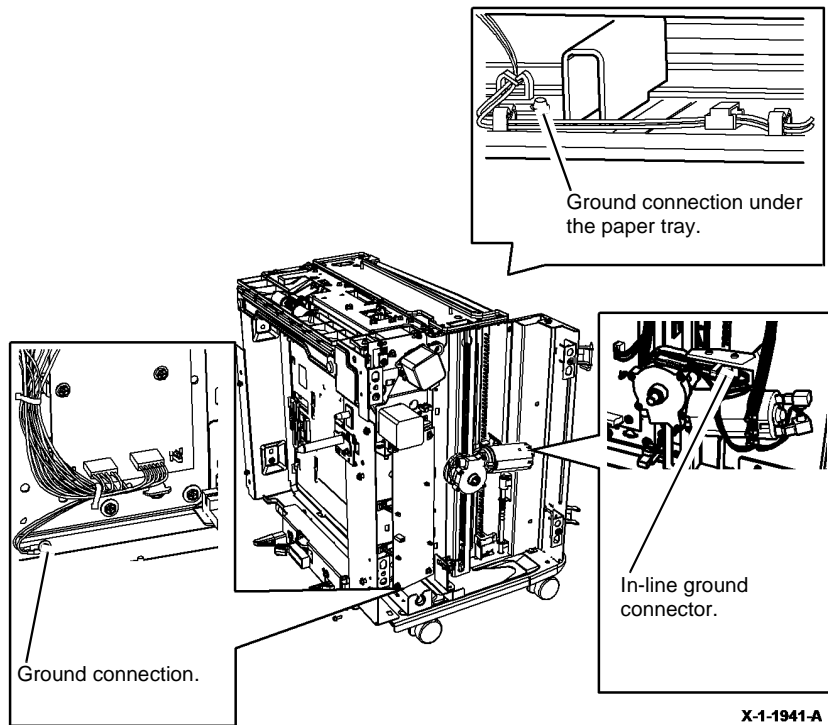
Figure 23 Tray 6 grounding

Refer to [Figure 23](#). Check the ground connection on the frame, the elevator motor and on the base of the paper tray. Ensure that the in-line connectors are fully connected.

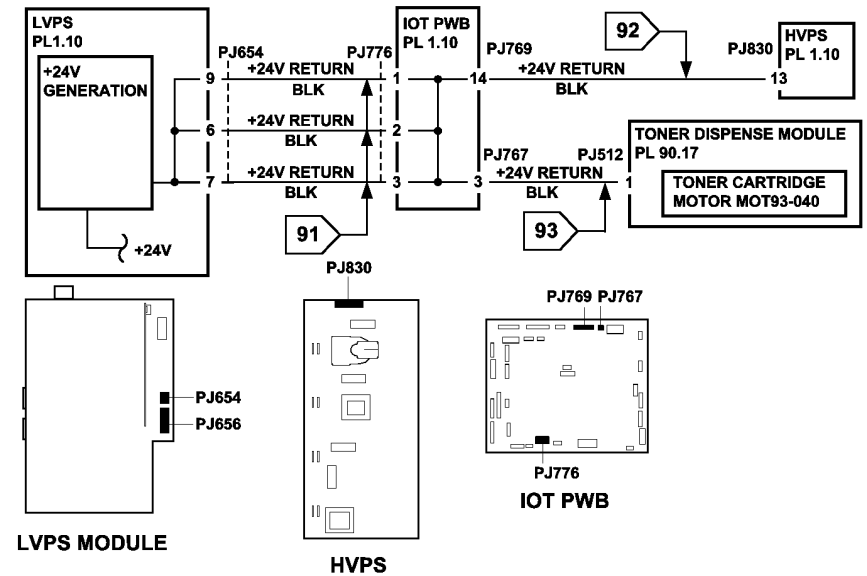
Figure 6 +24V return 1 of 2

- IOT PWB, PL 1.10 Item 2.
 - Flag 91, P/J776, P/J654.
- HVPS, PL 1.10 Item 3.
 - Flag 92, P/J830, P/J769.
 - Flag 91, P/J776, P/J654.

- Toner cartridge motor, part of the toner dispense module, PL 90.17 Item 1.
 - Flag 93, P/J512, P/J767.
 - Flag 91, P/J776, P/J654.
- SBC PWB, PL 3.22 Item 3.
 - Flag 94, P/J850, P/J655.
- Scanner PWB, PL 60.20 Item 4.
 - Flag 95, CN2, P/J861.
 - Flag 94, P/J850, P/J655.
- SPDH PWB, PL 5.10 Item 5.
 - Flag 96, CN12, CN3.
 - Flag 95, CN2, P/J861.
 - Flag 94, P/J850, P/J655.

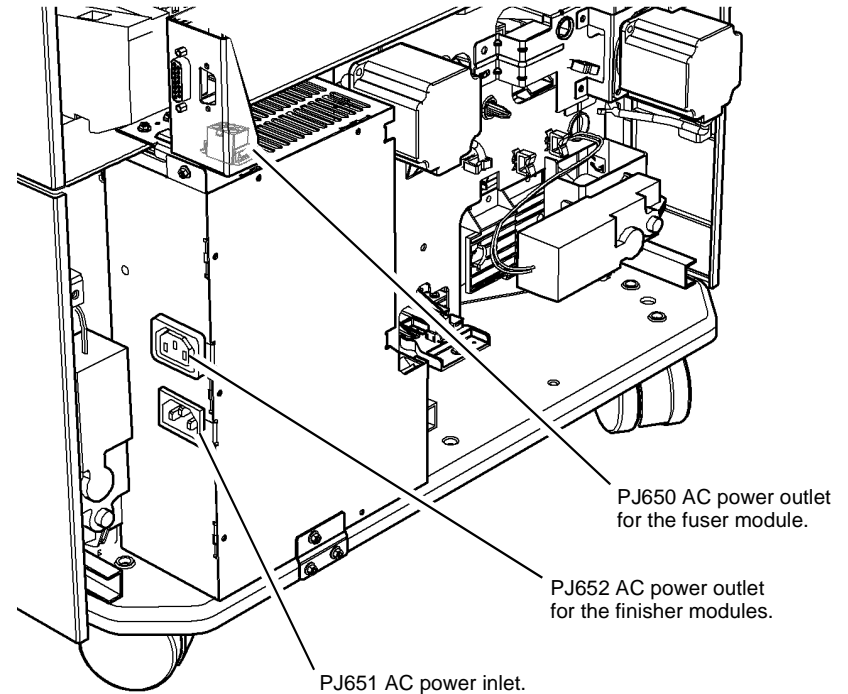
Figure 1 AC input and output

Check the power cords to the output device:

- 2K LCSS, PL 12.75 Item 8.
- HVF BM, PL 12.140 Item 4.
- LVF BM, PL 12.425 Item 4.

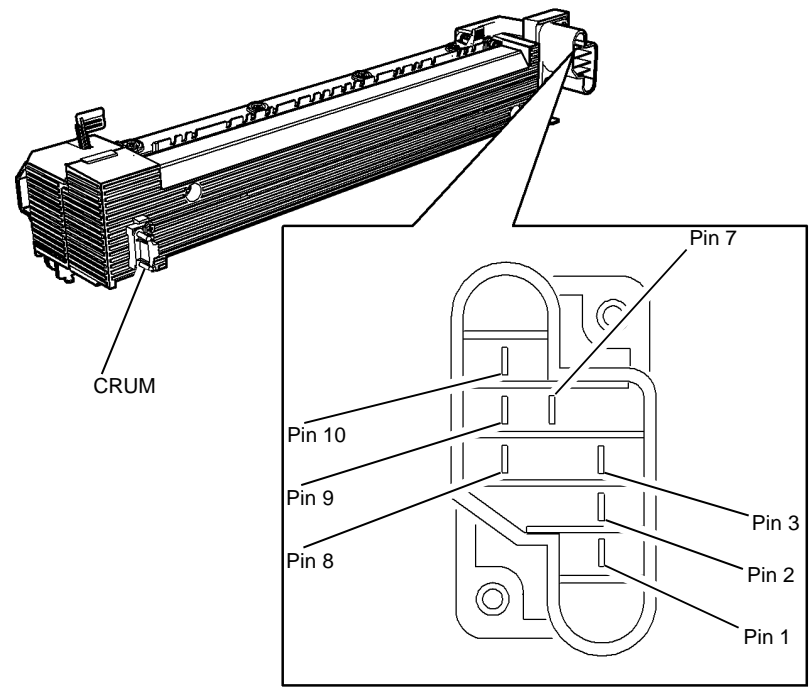
Figure 3 Fuser module

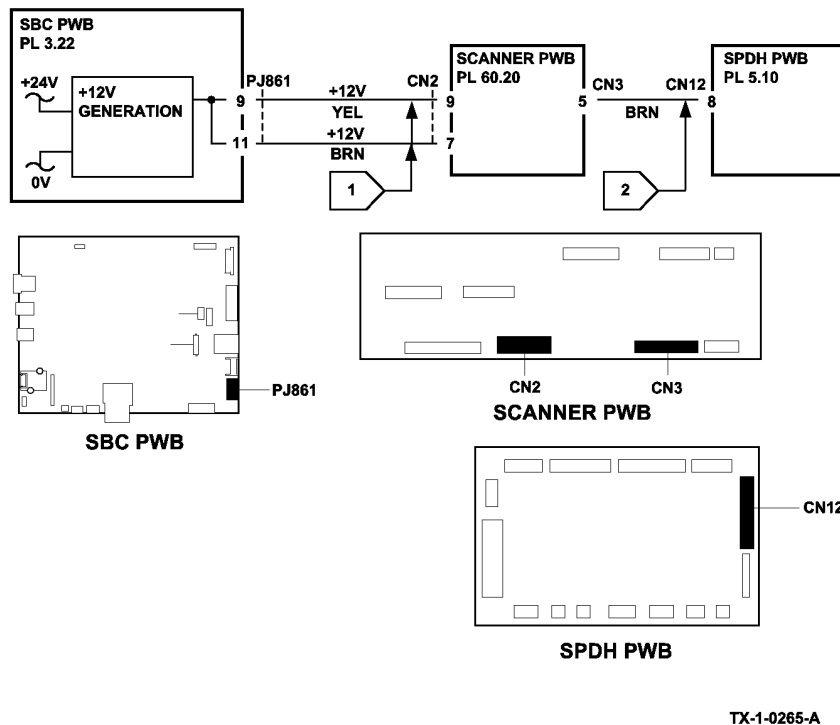
Figure 1 +12V Distribution

- SPDH PWB, PL 5.10 Item 5.
 - [Flag 1, P/J861, CN2.](#)
- Scanner PWB, PL 60.20 Item 4.
 - [Flag 2, CN3, CN12.](#)

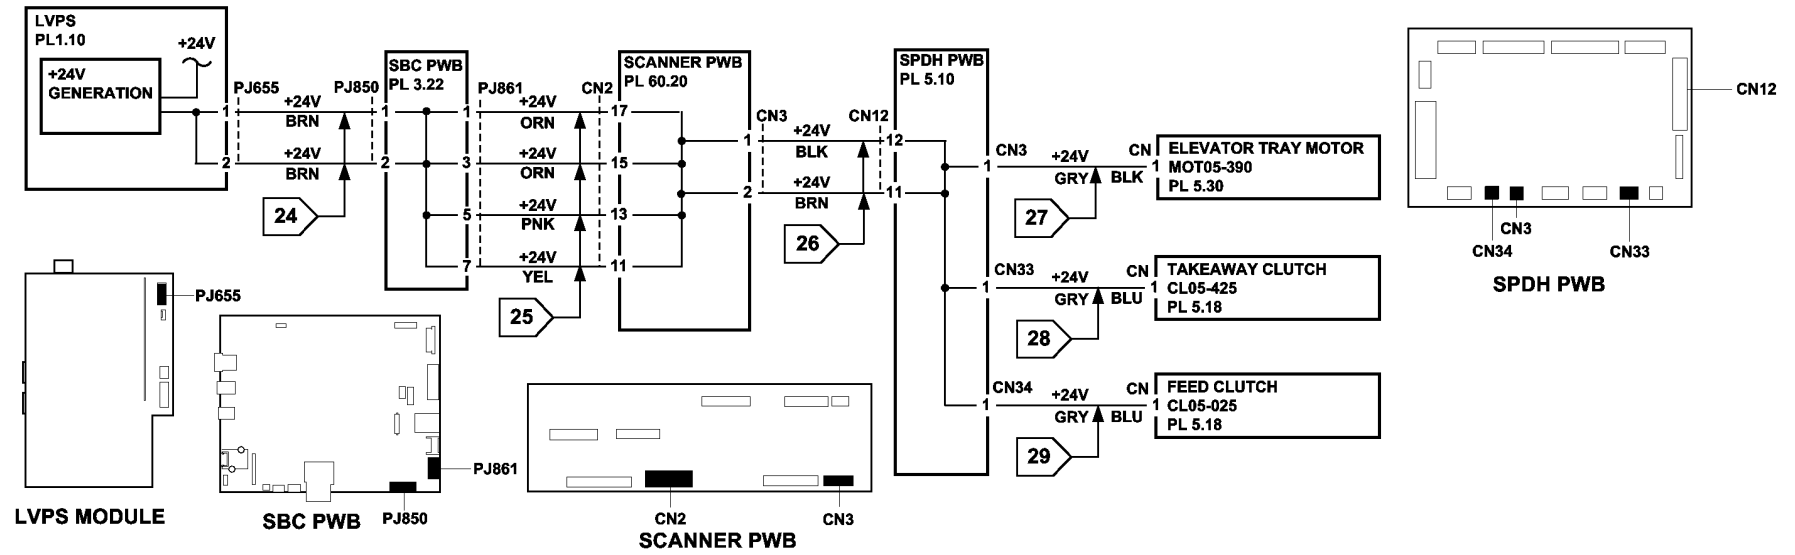
Figure 3 +24V Distribution 3 of 3

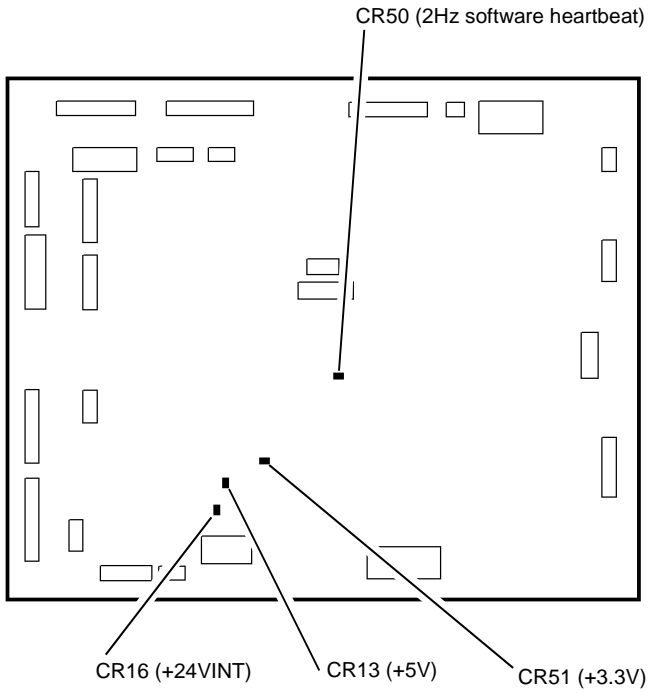
Figure 1 IOT PWB LEDs

1. Go to [Flag 10](#). Disconnect [P/J751](#). If CR13 and CR16 are now illuminated, repair the short circuit in the wiring to the tray 1 and tray 2 paper sensors. Refer to [WD 5](#). If after 10 seconds the LEDs remain off, reconnect [P/J751](#) and continue at the next check.
2. Go to [Flag 12](#). Disconnect [P/J755](#). If CR13 and CR16 are now illuminated, repair the short circuit in the wiring to the tray 3 paper sensors. Refer to [WD 6](#). If after 10 seconds the LEDs remain off, reconnect [P/J755](#) and continue at the next check.
3. Go to [Flag 13](#). Disconnect [P/J786](#). If CR13 and CR16 are now illuminated, repair the short circuit in the wiring to the tray 4 paper sensors. Refer to [WD 15](#). If after 10 seconds the LEDs remain off, reconnect [P/J786](#) and continue at the next check.

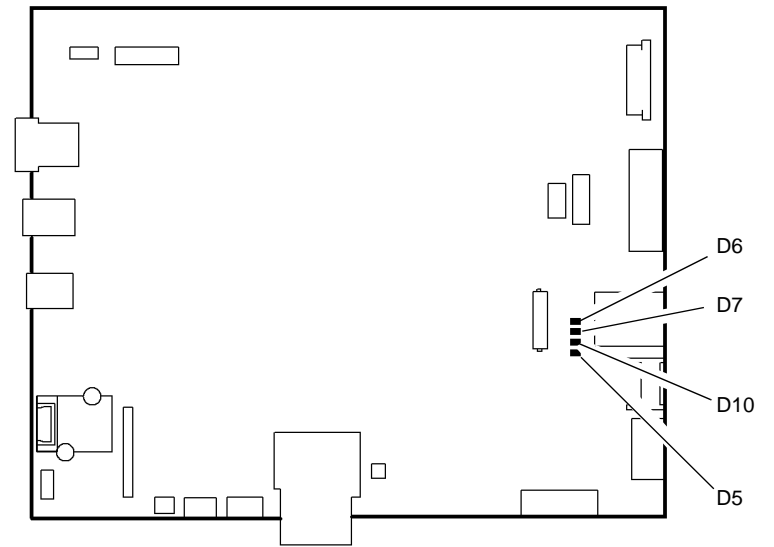
Figure 2 SBC PWB LEDs

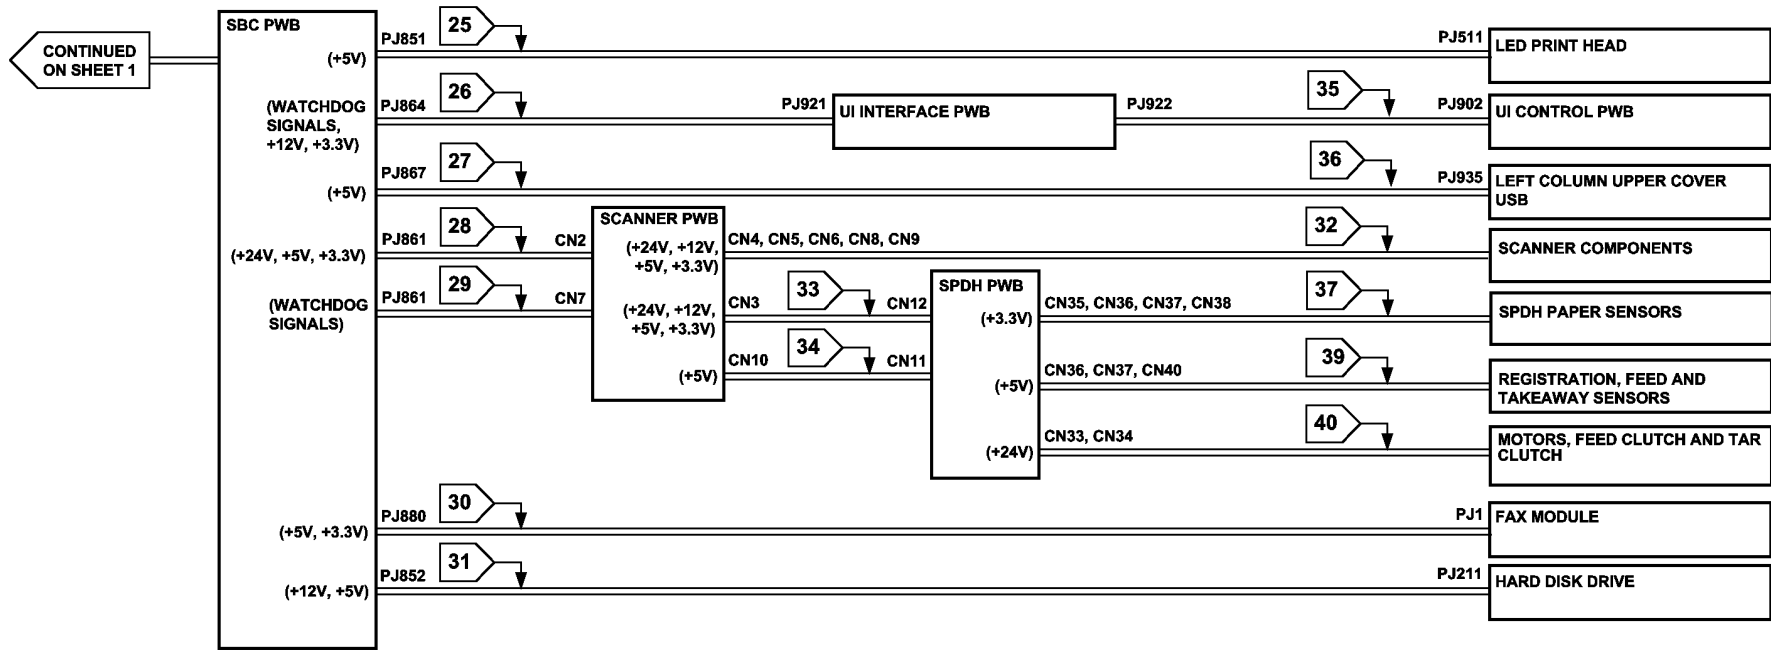
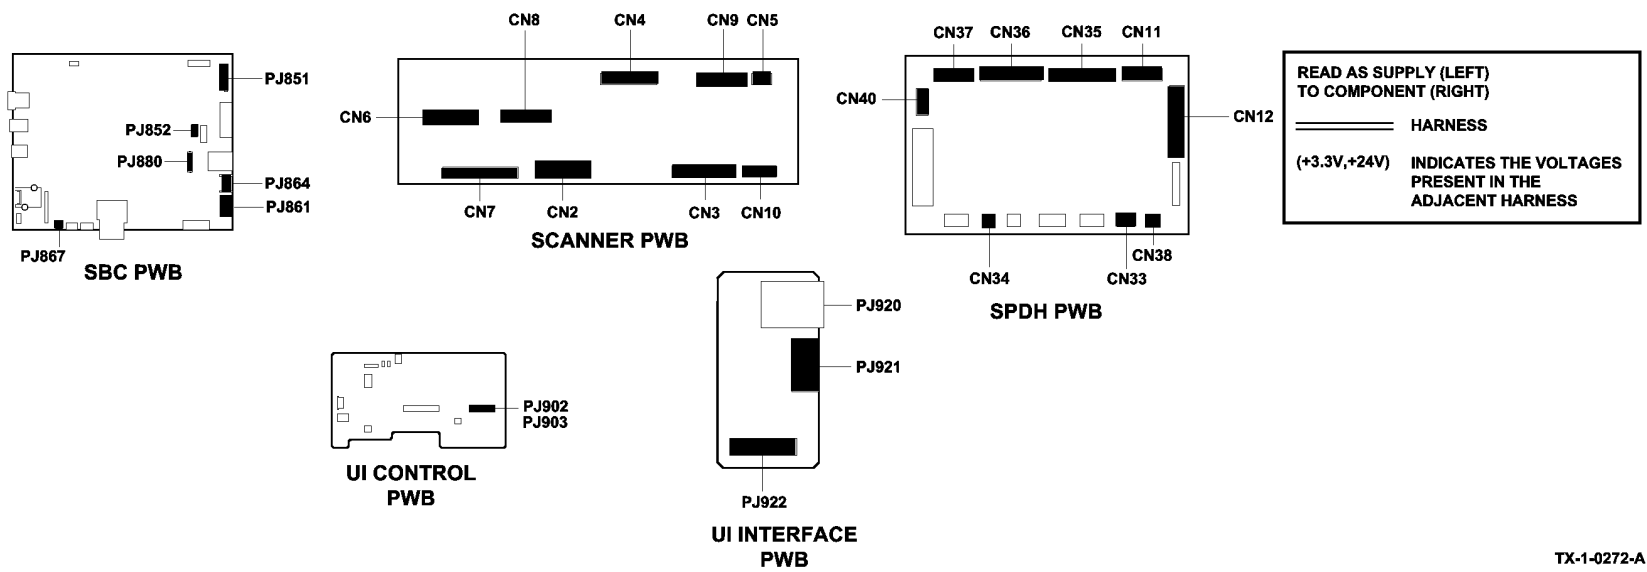
Figure 4 Low voltage distribution 2 of 2

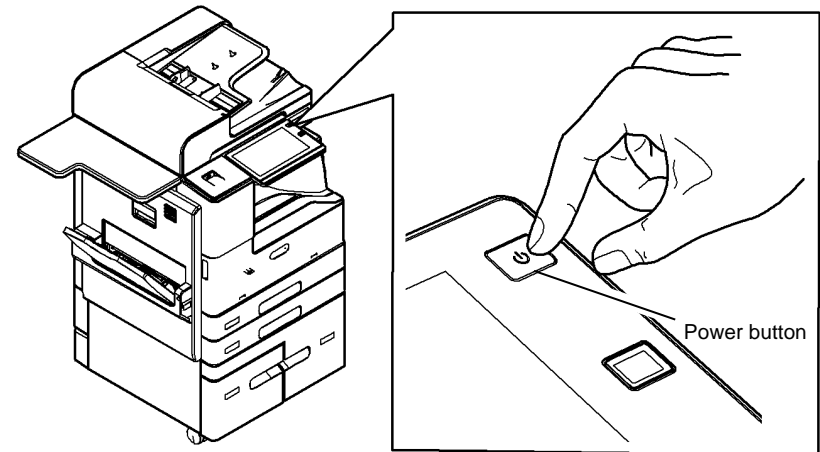
Figure 1 Power button location

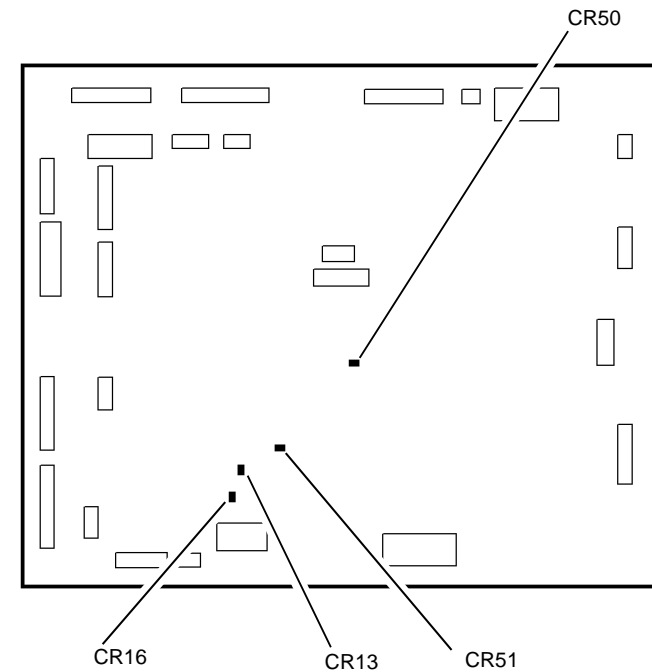
Figure 1 IOT PWB LED locations

- CR51 is illuminated yellow to indicate the presence of +3.3V (generated on the IOT PWB).

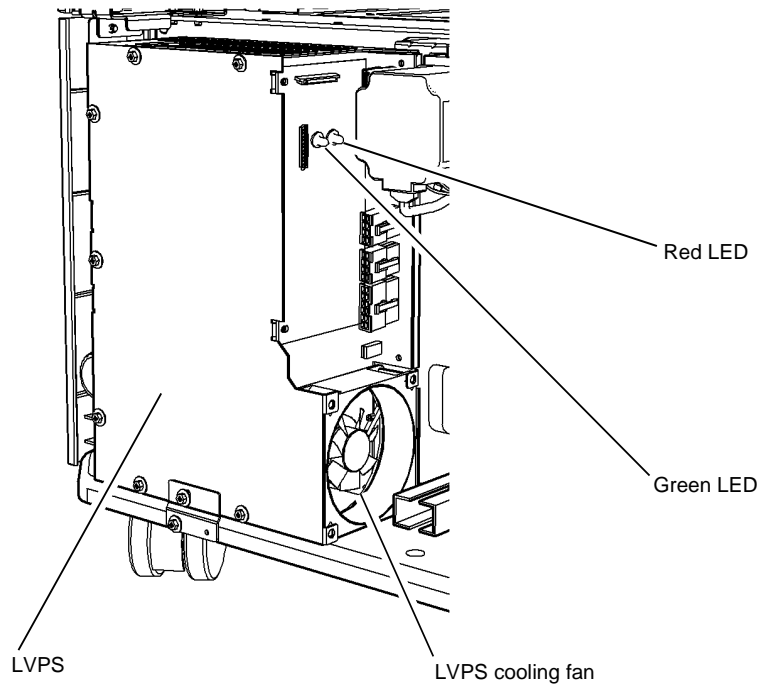
Figure 3 Component location

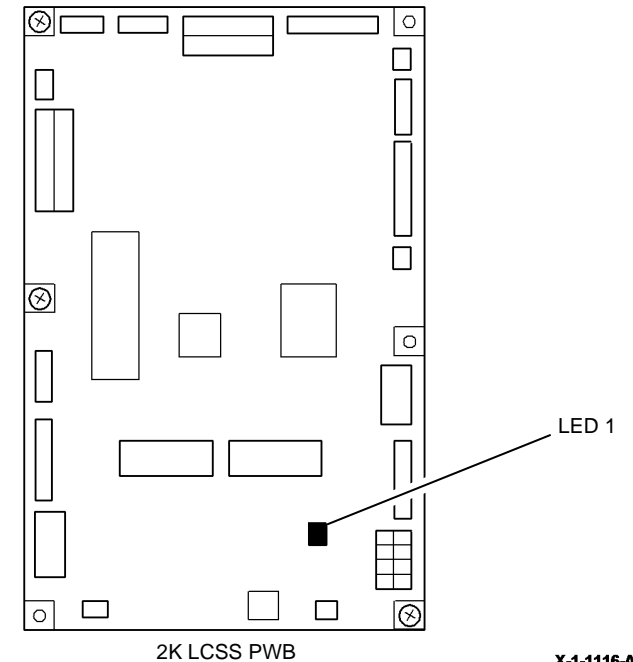
Figure 1 2L LCSS component location
