708P91368
September 2017

Xerox® AltaLink® B8090 Family Multifunction Printer Service Manual

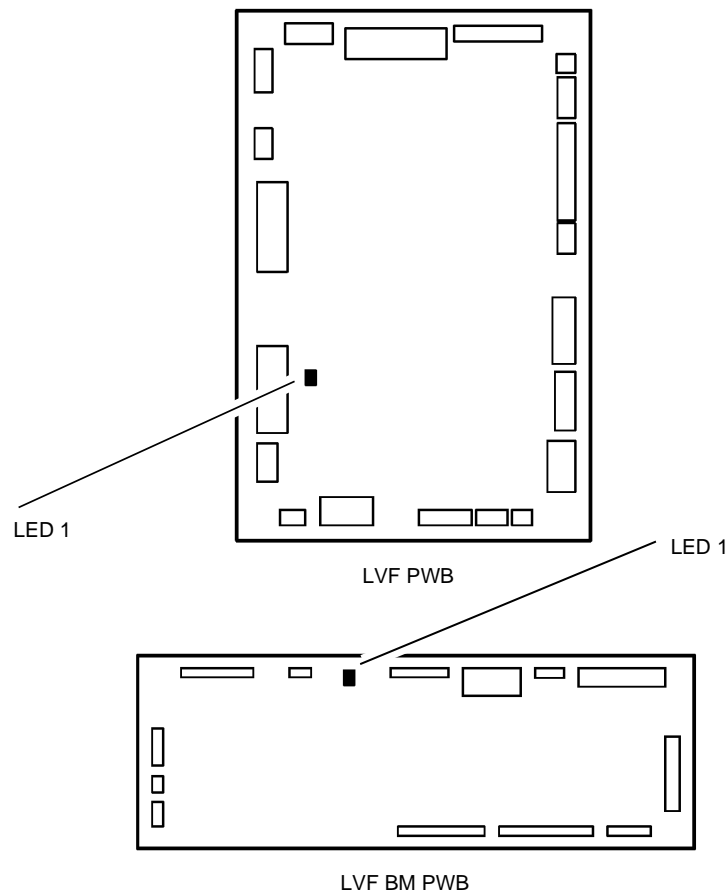
Figure 2 Component location

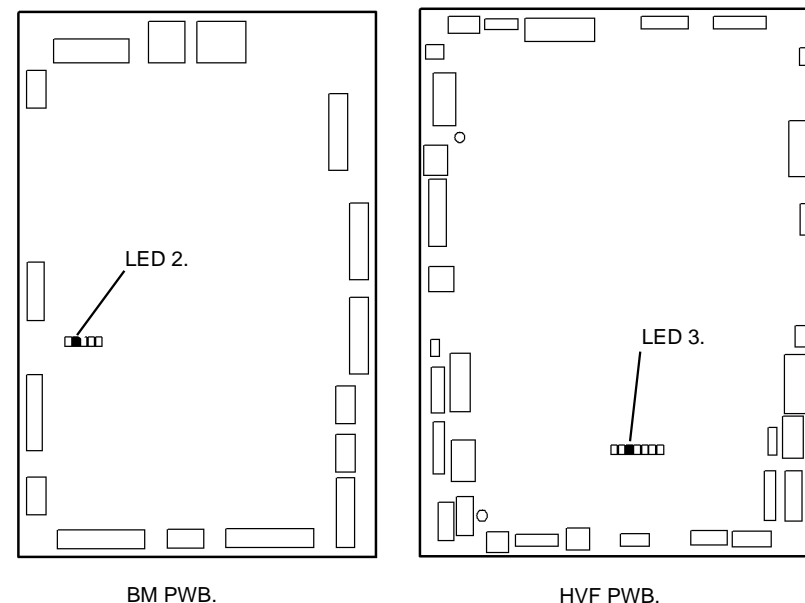
Figure 3 Component location

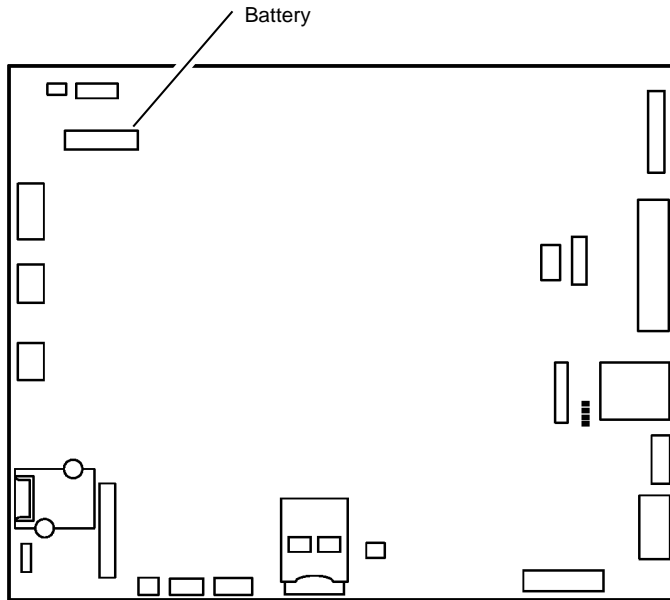
Figure 2 SBC PWB

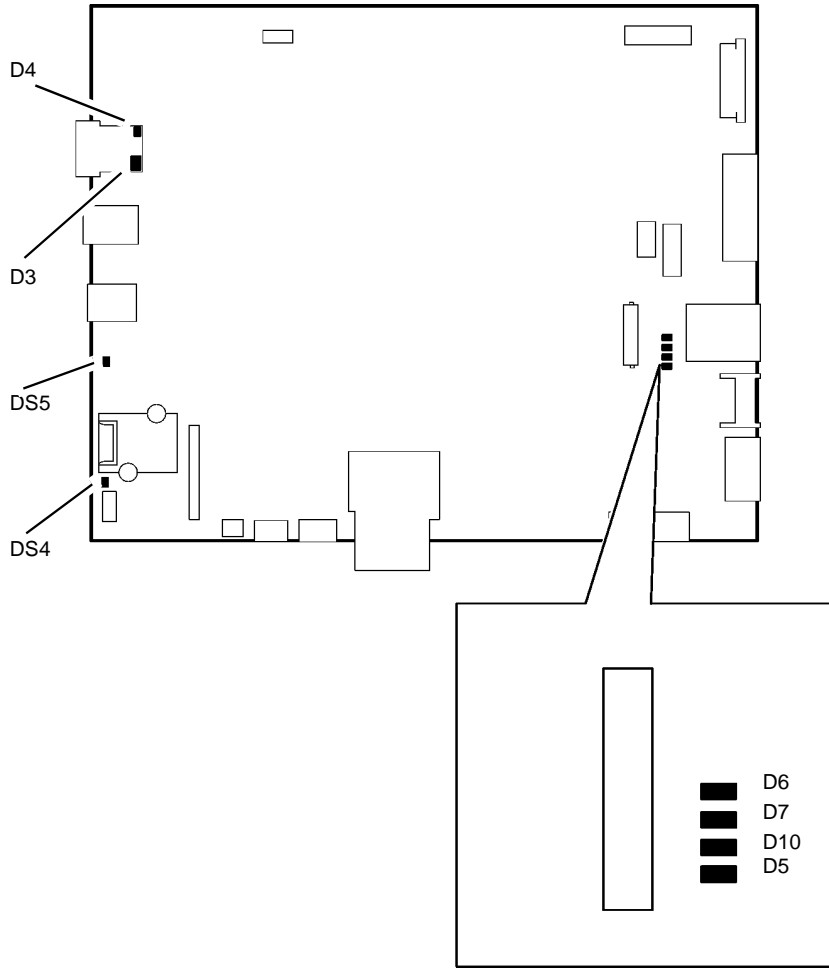
Figure 2 SBC PWB LED locations

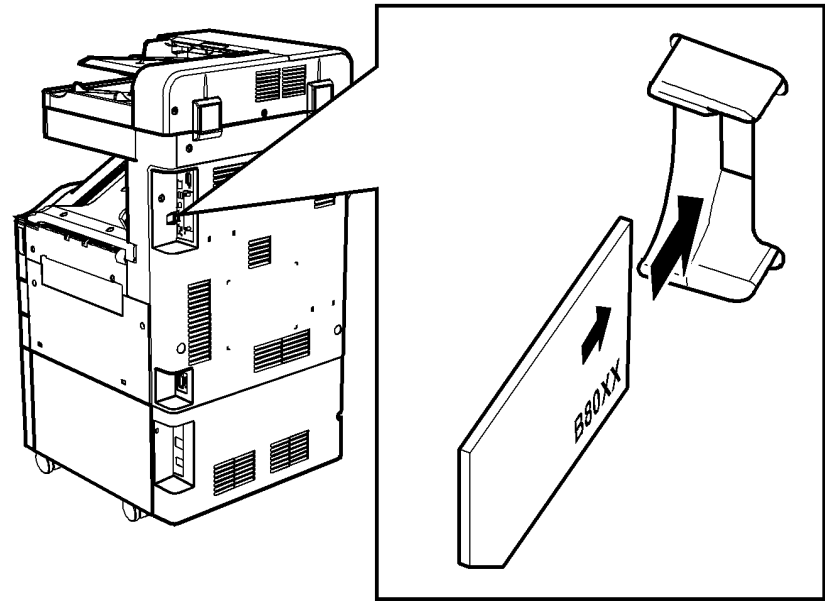
Figure 3 SIM Card orientation

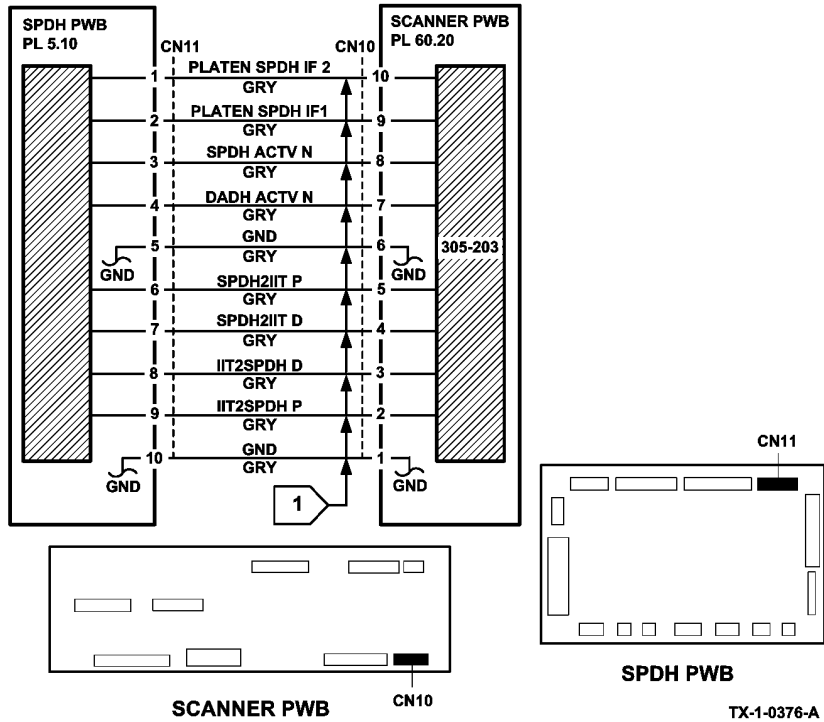
Figure 1 Circuit diagram

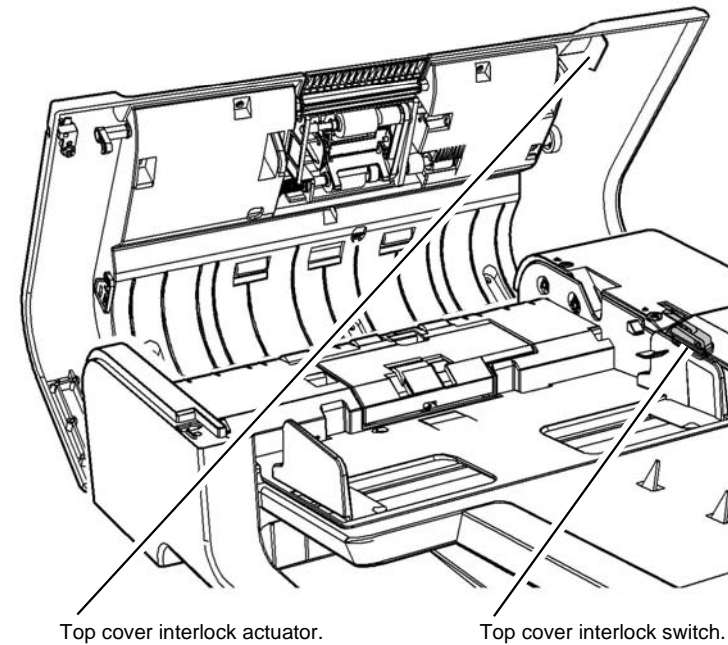
Figure 1 Component location

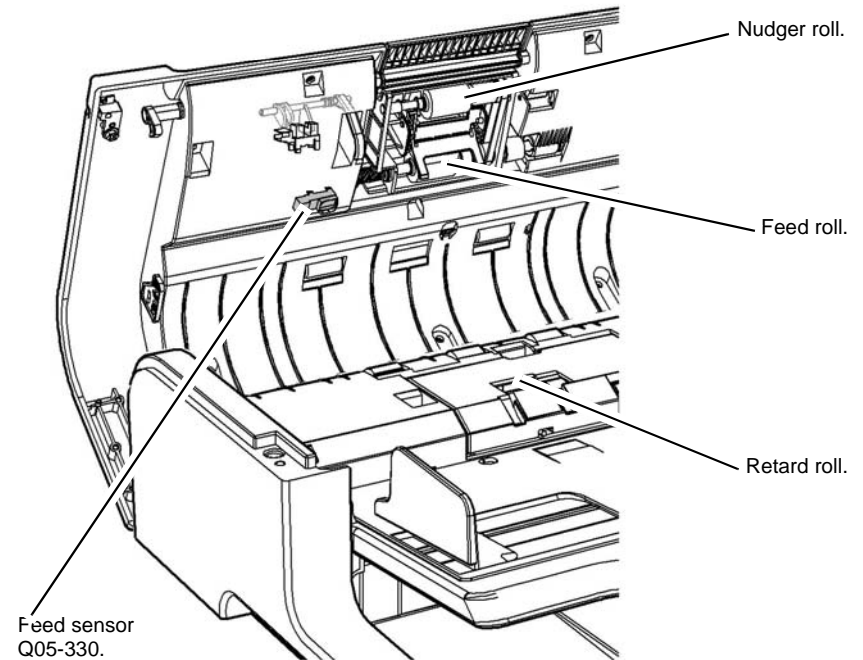
Figure 1 Component location

- Ensure that the SPDH is connected to ground correctly. Refer to [301A](#) Ground Distribution RAP.
- Check the condition and operation of the items that follow. If necessary clean the items or install new components:
 - Feed roll, [PL 5.20 Item 17](#).
 - Nudger roll, [PL 5.20 Item 6](#).
 - Retard roll, [PL 5.25 Item 3](#).
- Check for a malfunction of the doc present sensor, Q05-309. Perform the [305B](#) Doc Present Failure RAP.
- Check the correct location and mechanical operation of the stack height sensor, Q05-310 and the stack height sensor actuating arm, [Figure 1](#). Refer to [REP 5.8](#).

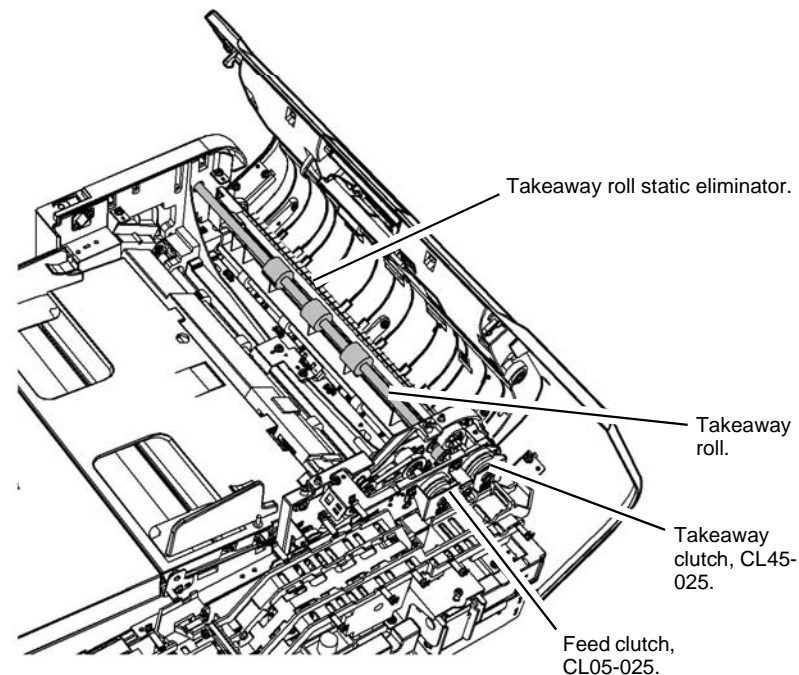
X-1-1944-A

Figure 1 Component location

- Check the takeaway roll static eliminator, Figure 1.
- Ensure that the SPDH is connected to ground correctly. Refer to 301A Ground Distribution RAP.
- Check the condition and operation of the items that follow. If necessary clean the items or install new components:
 - Feed roll, PL 5.20 Item 17.
 - Nudger roll, PL 5.20 Item 6.
 - Retard roll, PL 5.25 Item 3.

- Check for a malfunction of the doc present sensor, Q05-309. Perform the 305B Doc Present Failure RAP.
- Check the correct location and mechanical operation of the stack height sensor, Q05-310 and the stack height sensor actuating arm, Figure 1. Refer to REP 5.8.

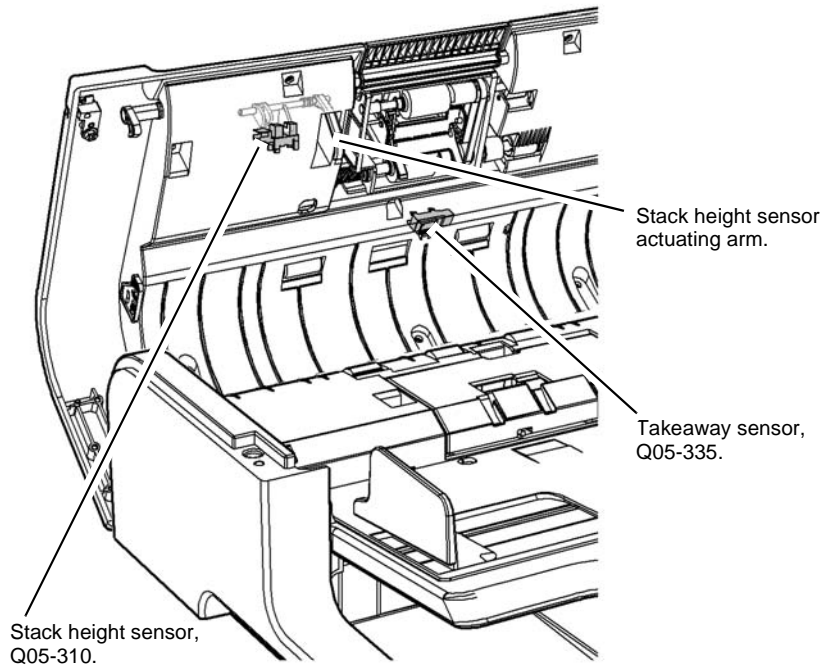
X-1-1993-A

Figure 2 Component location

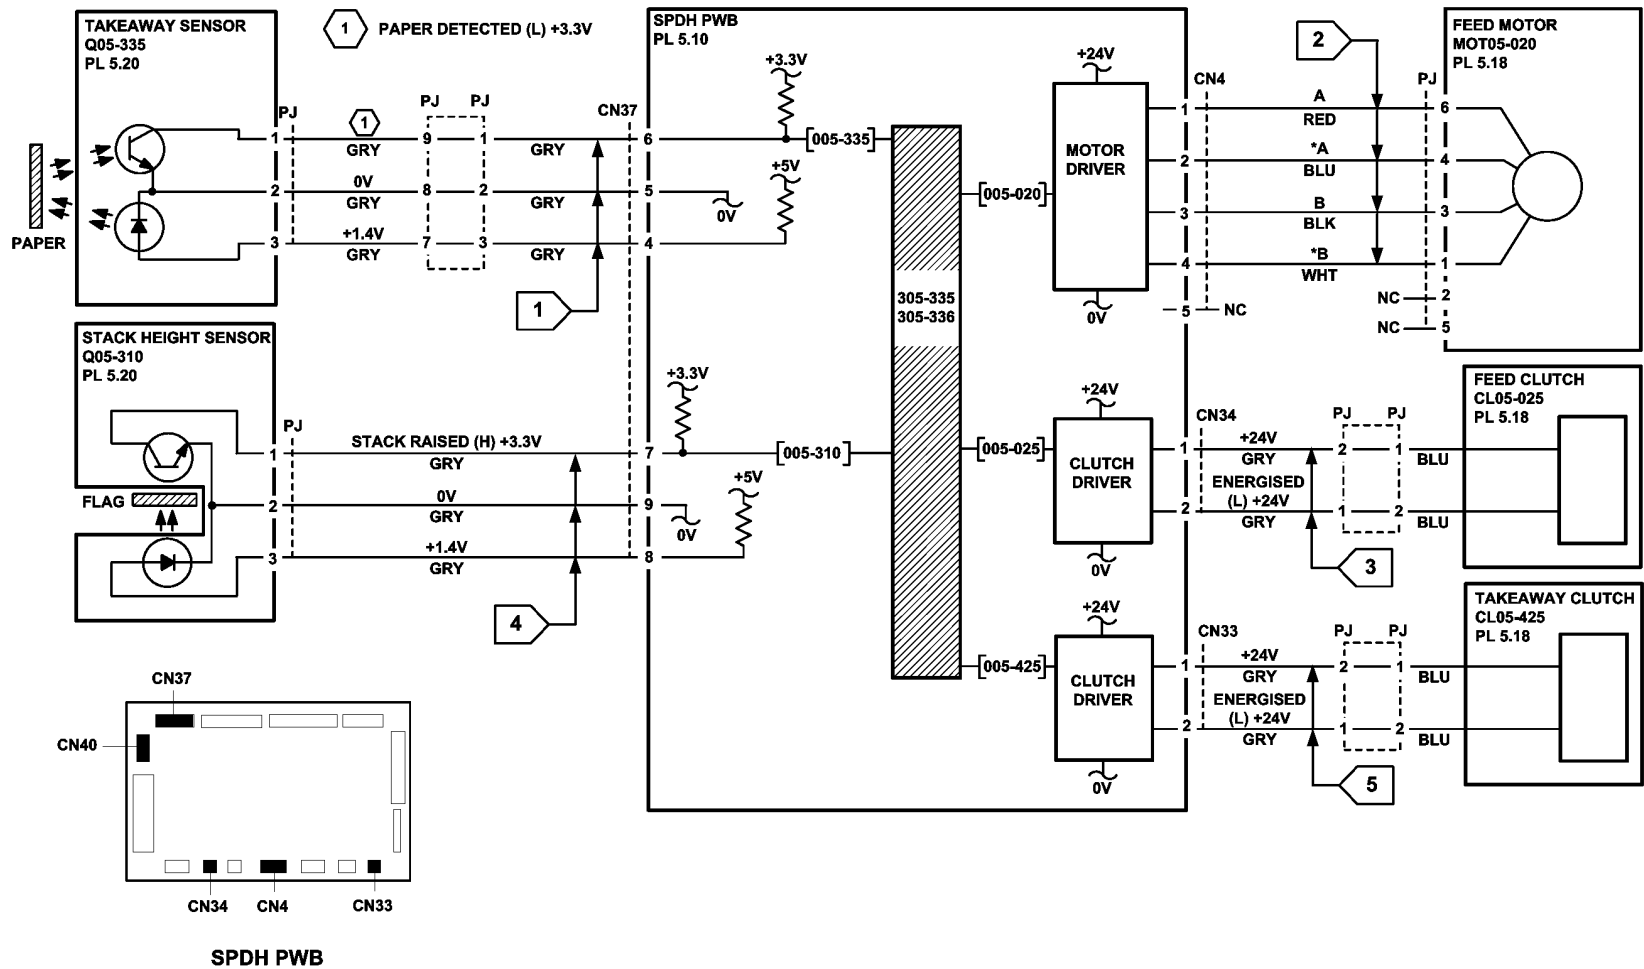
TX-1-0379-A

Figure 3 Circuit diagram

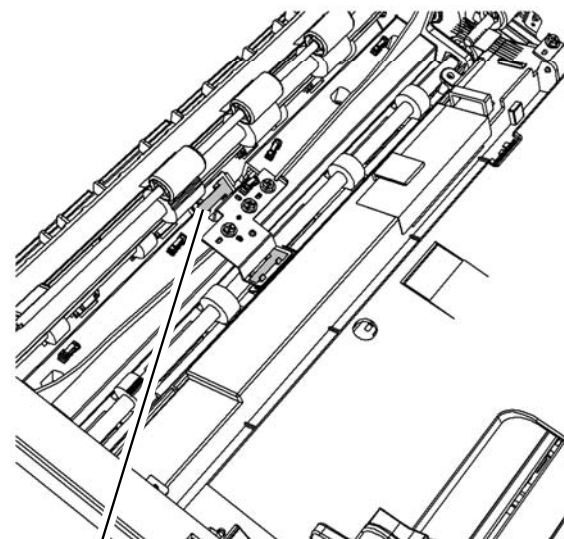
X-1-1948-A

Reg sensor, Q05-340.

Figure 1 Component location

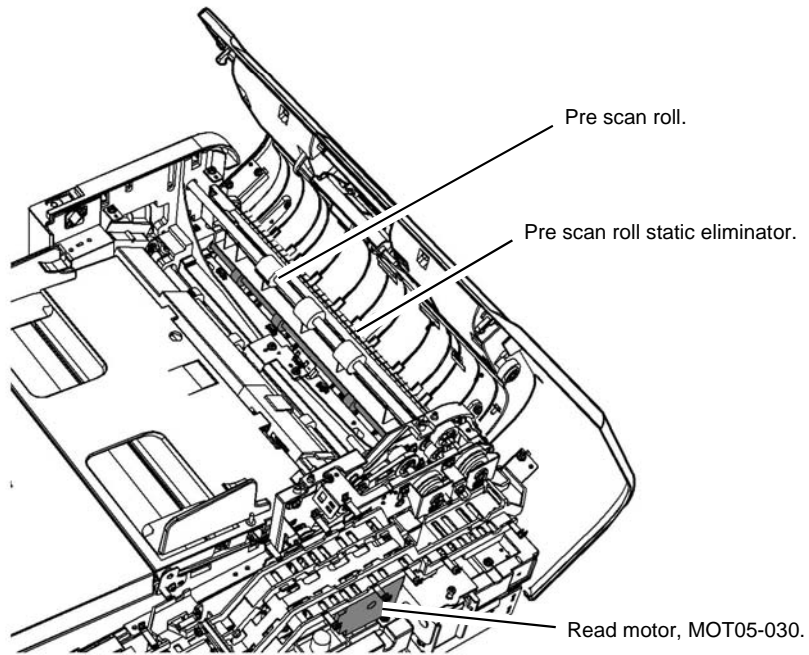
X-1-1945-A

Figure 2 Component location

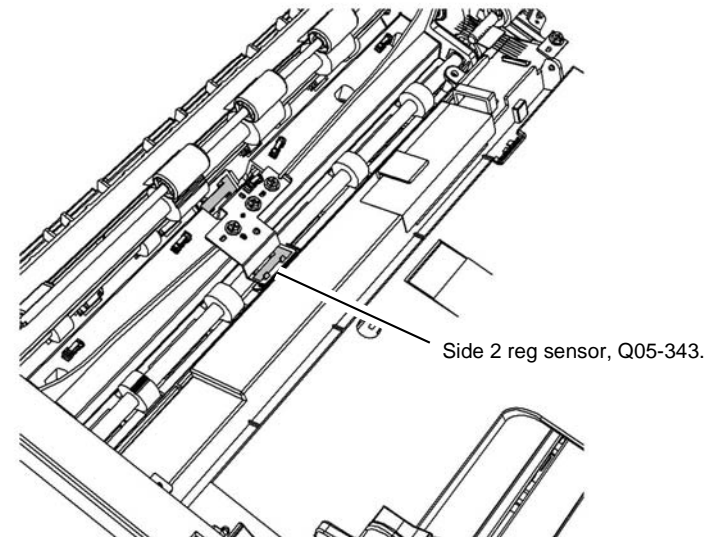
X-1-1949-A

Figure 1 Component location

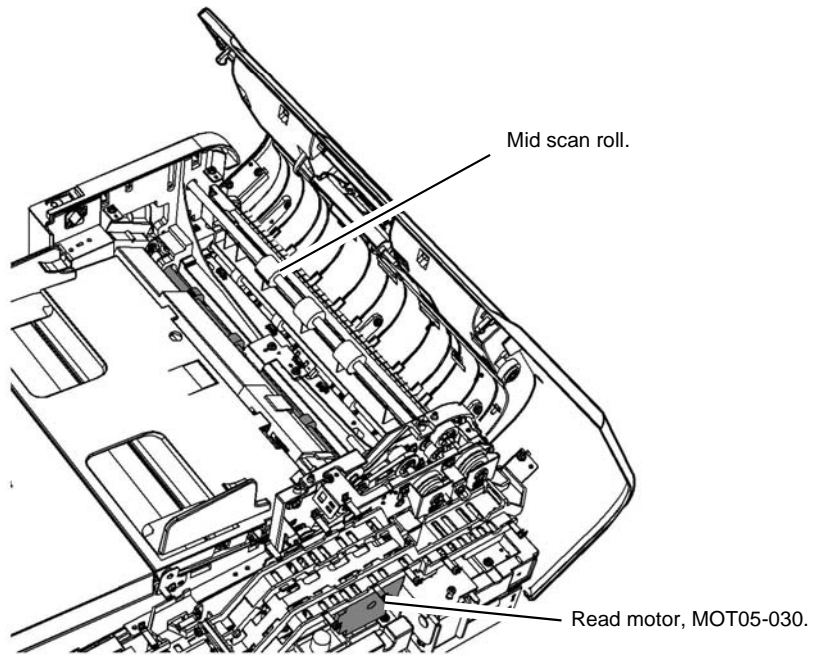
X-1-1946-A

Figure 2 Component location

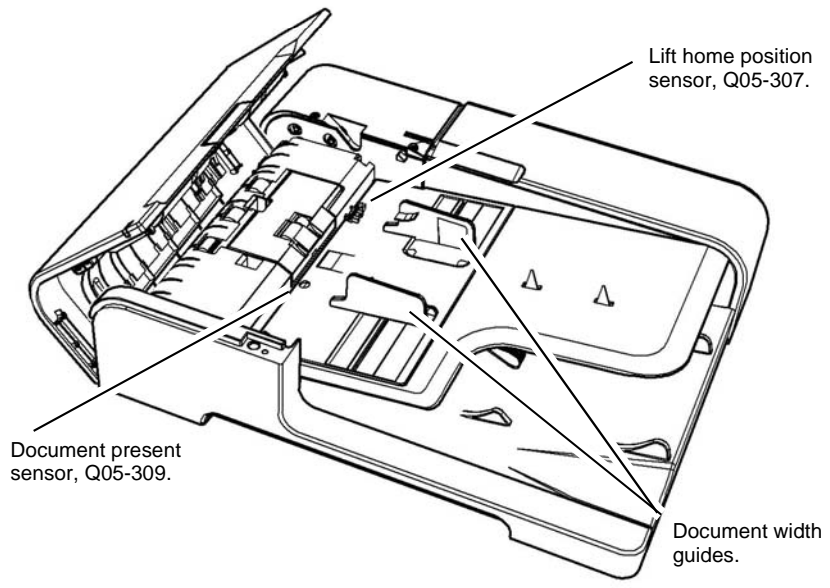
X-1-1991-A

Figure 1 Component location

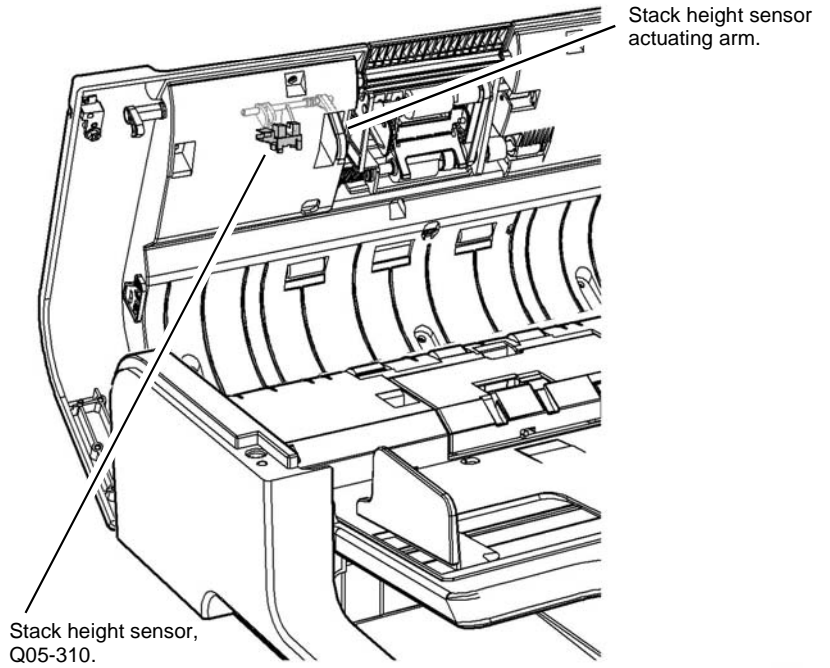
X-1-1992-A

Figure 2 Component location

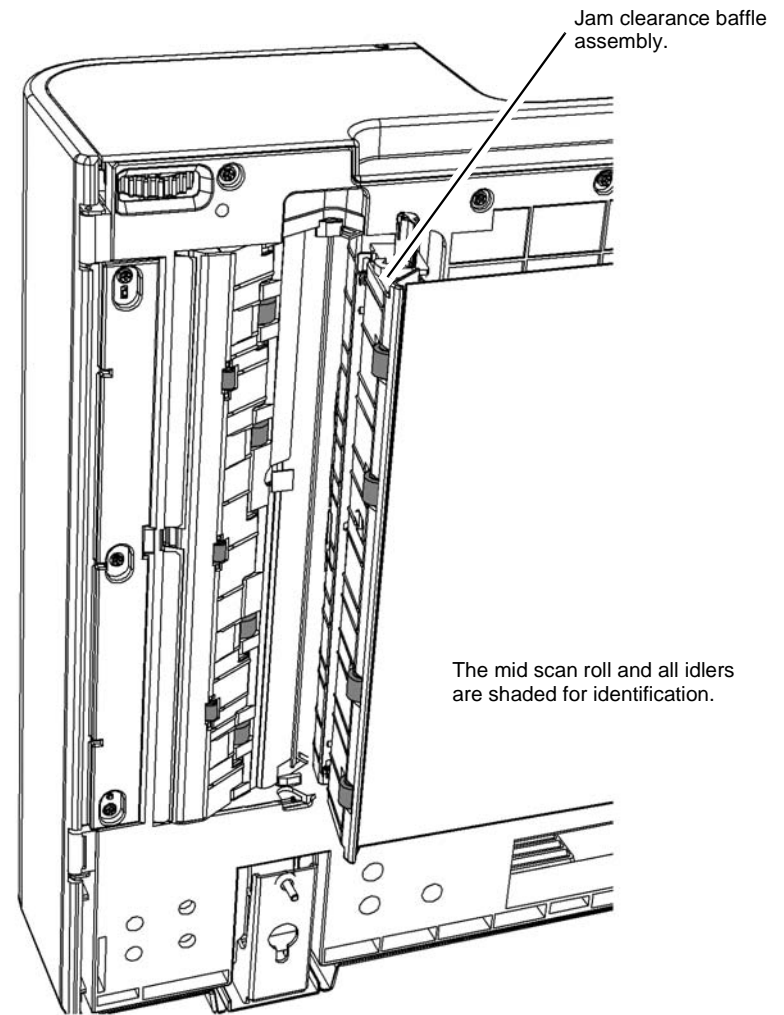
X-1-1956-A

Figure 1 Component location

4. Raise the SPDH. Lower the jam clearance baffle assembly, Figure 1.
 - Check for, and remove any pieces of paper.
 - Check the document path in the baffle area for damage.

- Check the jam clearance baffle assembly for damage.
 - Check the mid scan roll, PL 5.17 Item 3 and the surrounding idlers, Figure 1 for contamination or damage. Ensure that the roll and idlers are clean and rotate freely, ADJ 5.3 SPDH Cleaning Procedure.

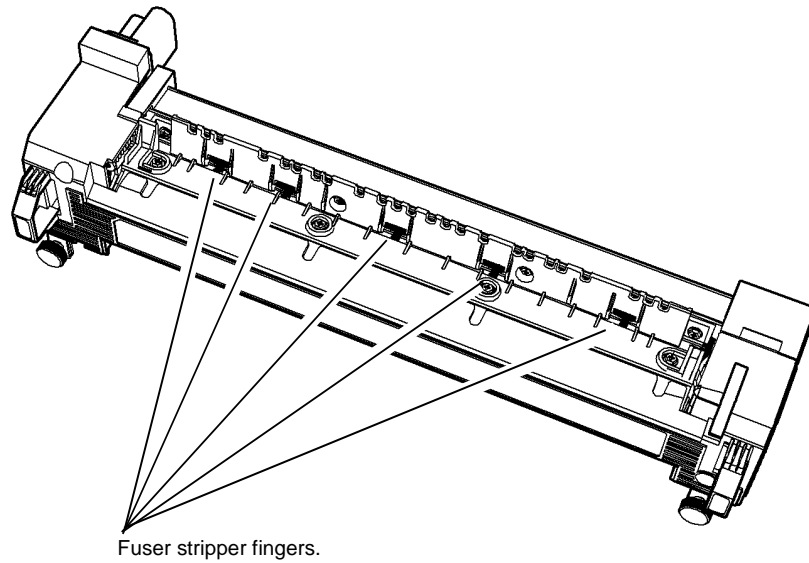
X-1-1081-A

Figure 1 Component location

- The fuser module, [PL 10.8 Item 1](#) for damage.
- The fuser stripper fingers for contamination, [Figure 1](#).
- The fuser settings in [dC131](#). Refer to NVM locations 502-292 through to 502-296. Ensure that the values are set to the default level.
- For paper skew. Refer to [IQ8 Skew RAP](#).
- For worn, damaged or missing photoreceptor stripper fingers. If necessary install a new print cartridge, [PL 90.17 Item 9](#).

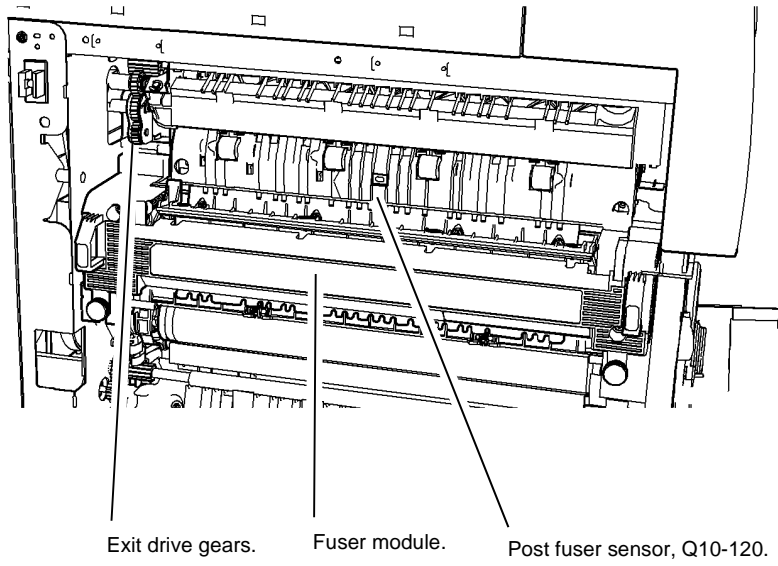
X-1-1091-A

Figure 2 Component location

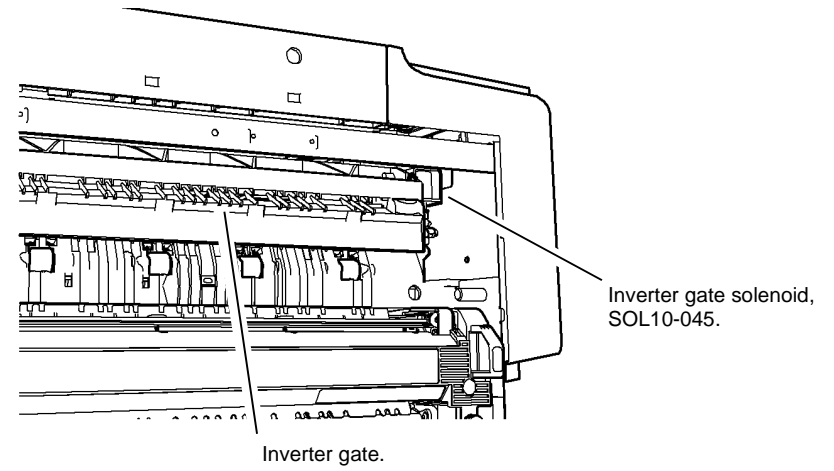
X-1-1092-A

Figure 3 Component location

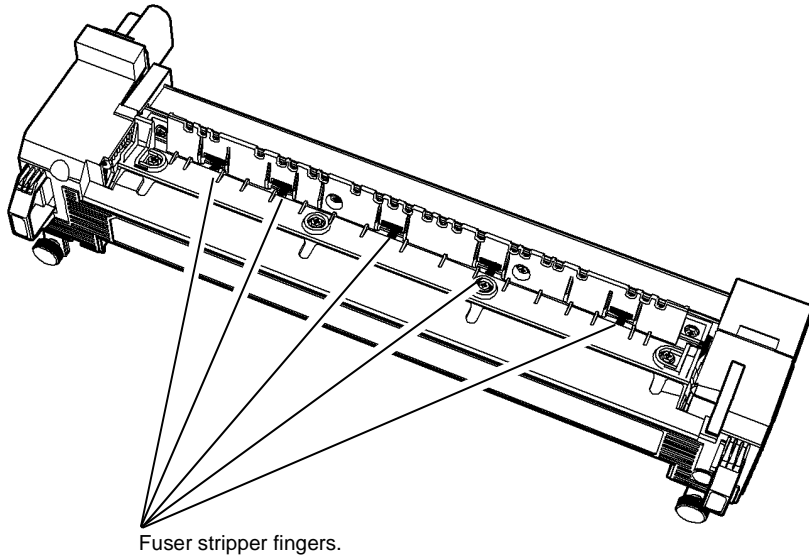
X-1-1093-A

Figure 1 Component location

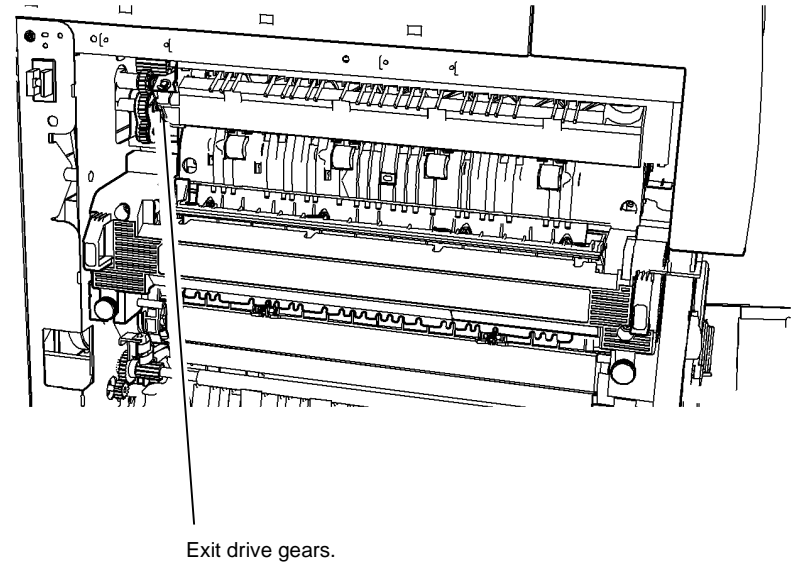
X-1-1105-A

Figure 2 Component location

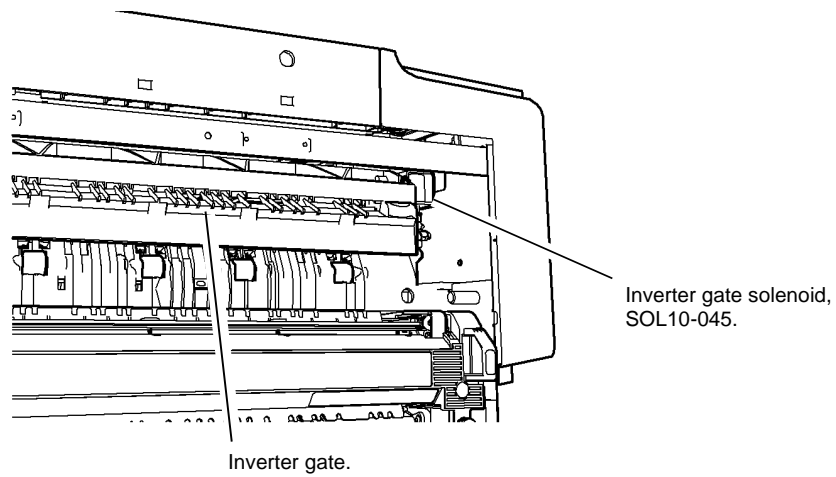
X-1-1094-A

Figure 3 Component location

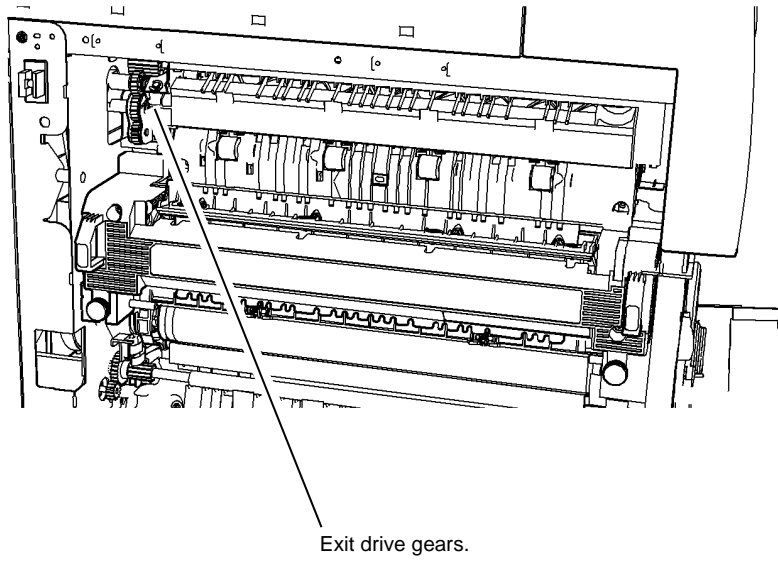
X-1-1106-A

Figure 1 Component location

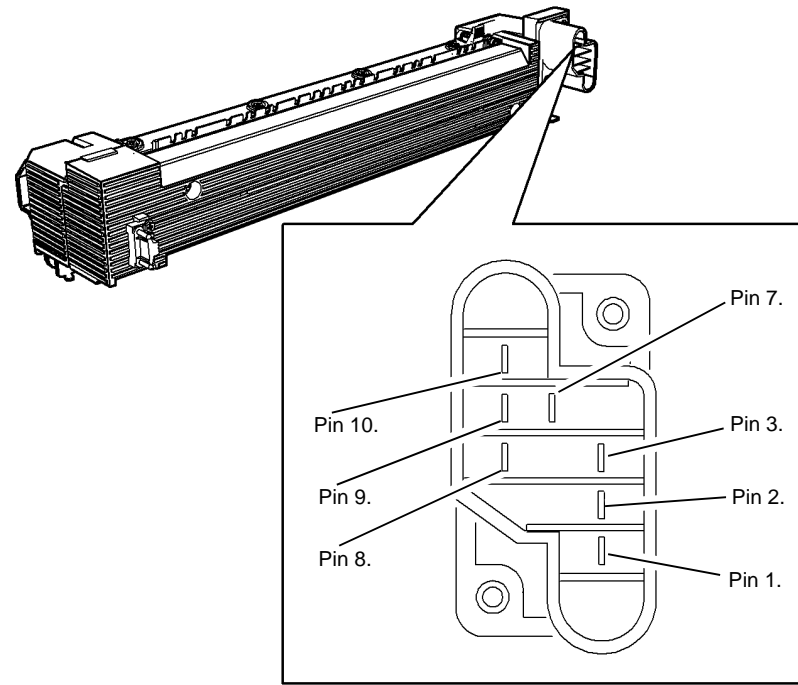
X-1-0959-A

Figure 1 Component location

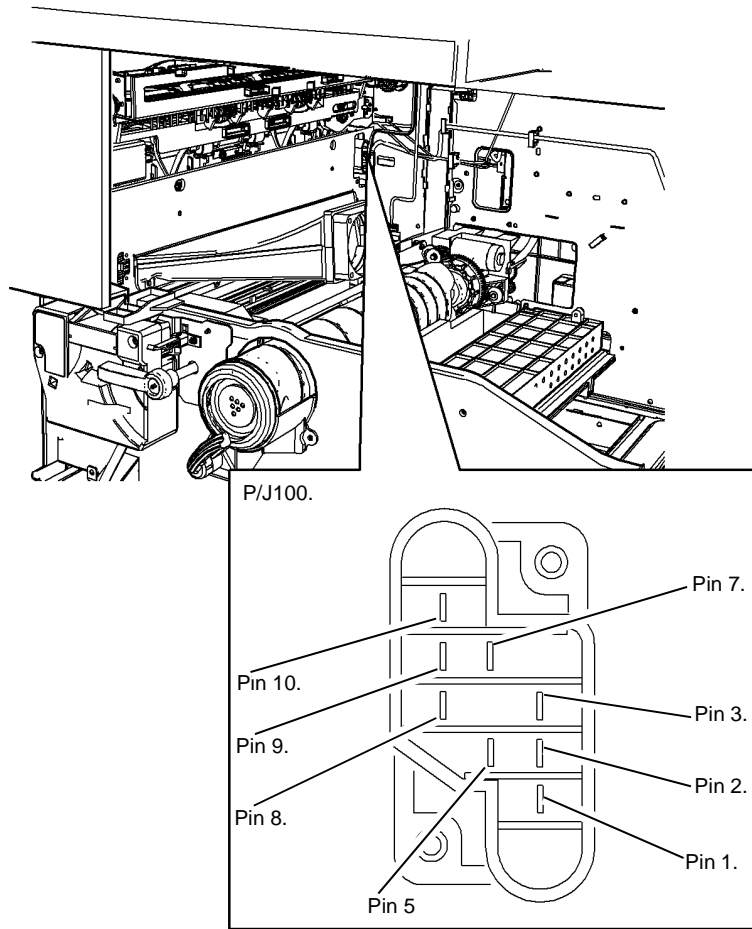
X-1-0961-A

Figure 2 Component location

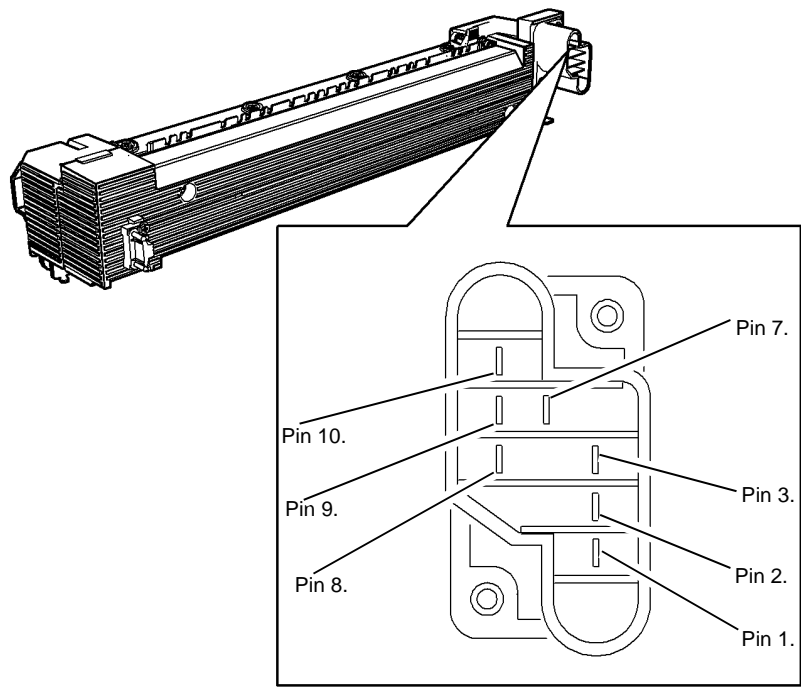
X-1-0960-A

Figure 1 Component location

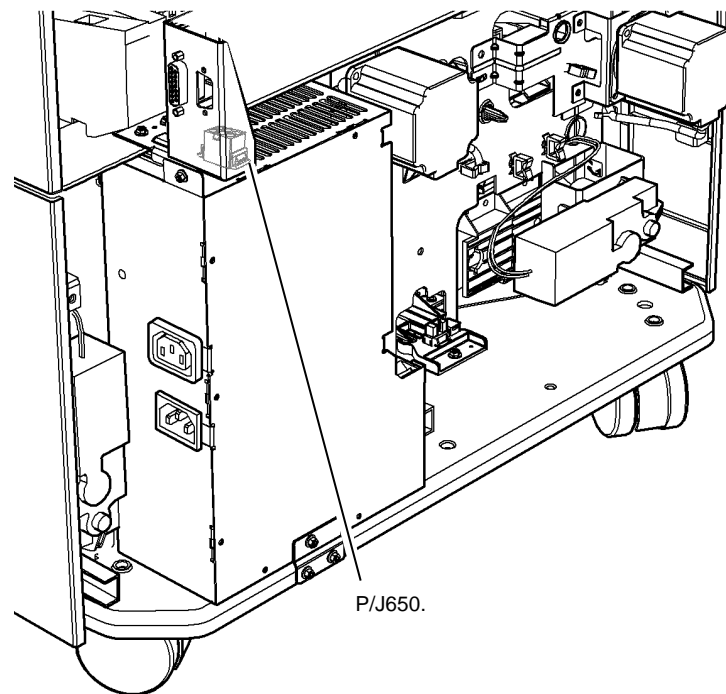
X-1-0963-A

Figure 2 Component location

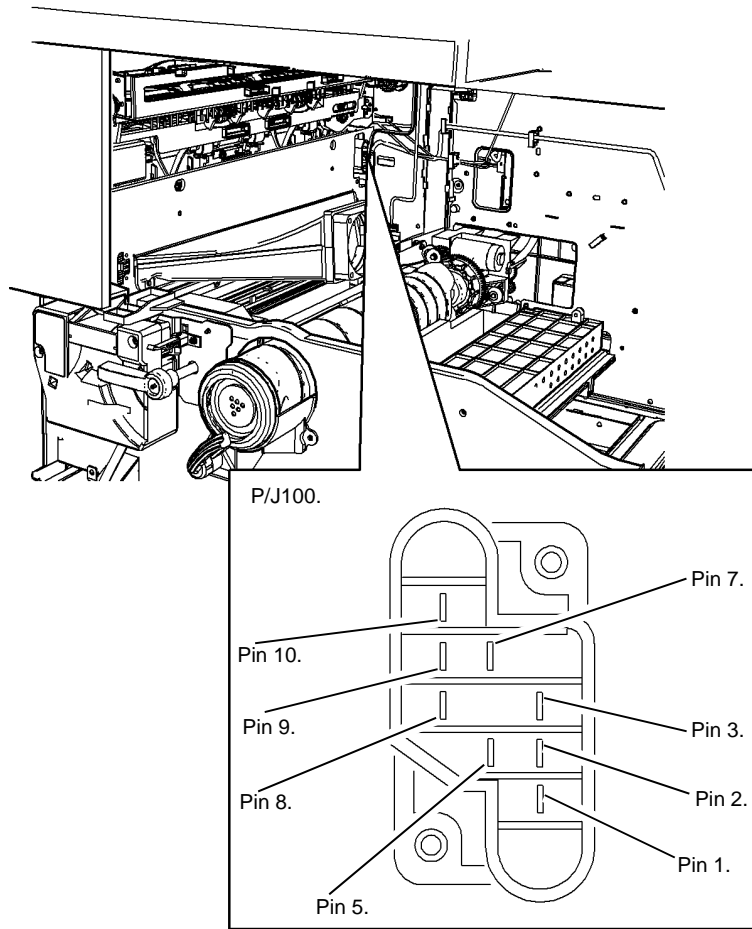
X-1-0962-A

Figure 3 Component location

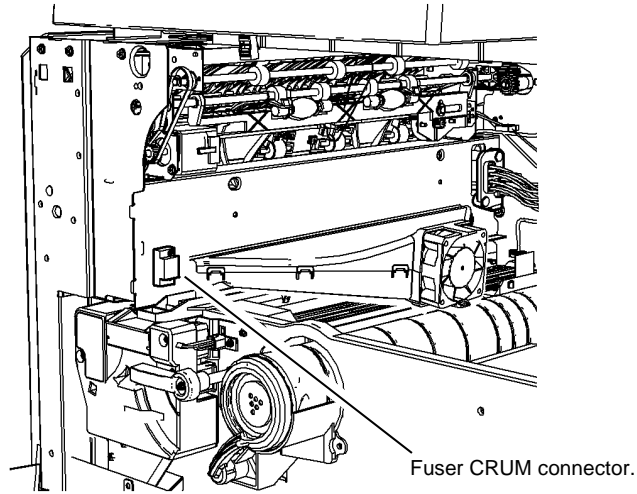
X-1-1074-A

Figure 1 Fuser CRUM connector location

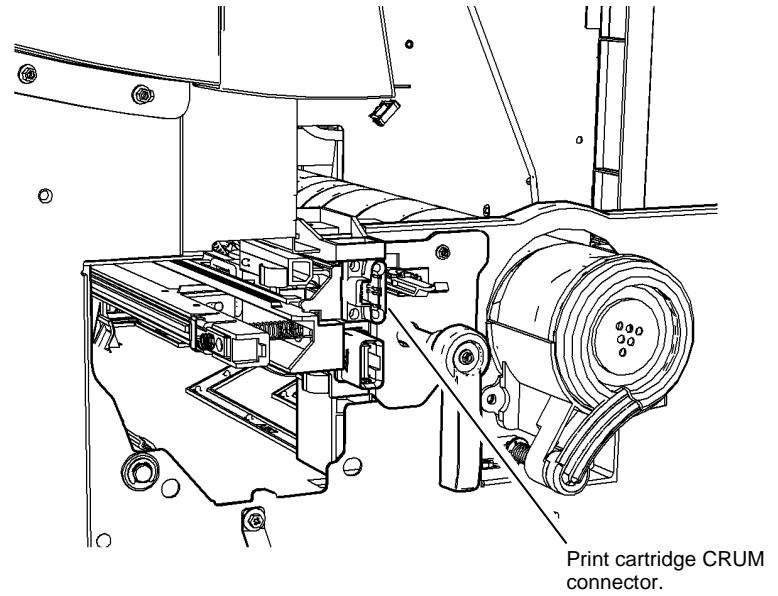
X-1-1075-A

Figure 2 Print cartridge CRUM connector location

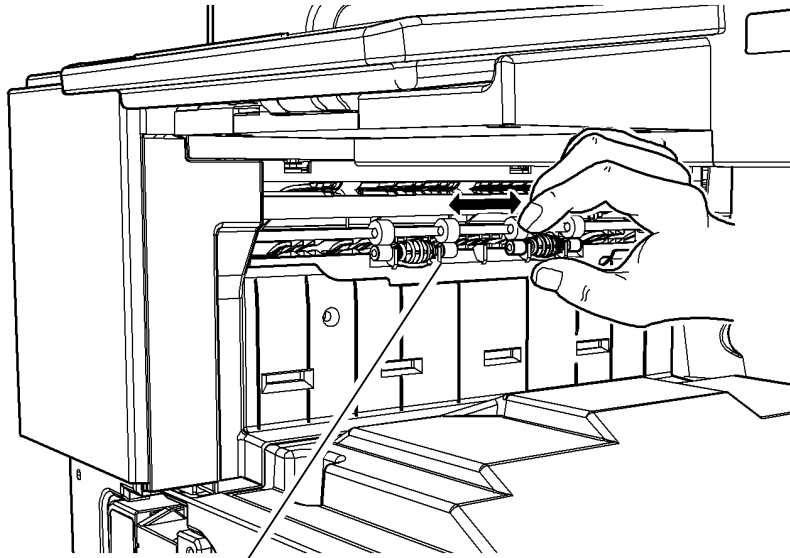
Figure 1 Component location

Offset shuttle and rolls.

- Check for an incorrect mesh between the offset motor pinion, [PL 10.11 Item 14](#) and the shuttle rack teeth, [PL 10.11 Item 22](#). Loosen the two screws securing the offset motor bracket, [PL 10.11 Item 15](#) to the exit guide housing, [PL 10.11 Item 2](#). Move the motor bracket up as far as possible, then re-tighten the screws.
- Offset shuttle, [PL 10.11 Item 22](#).
- Inverter assembly, [PL 10.10 Item 1](#).

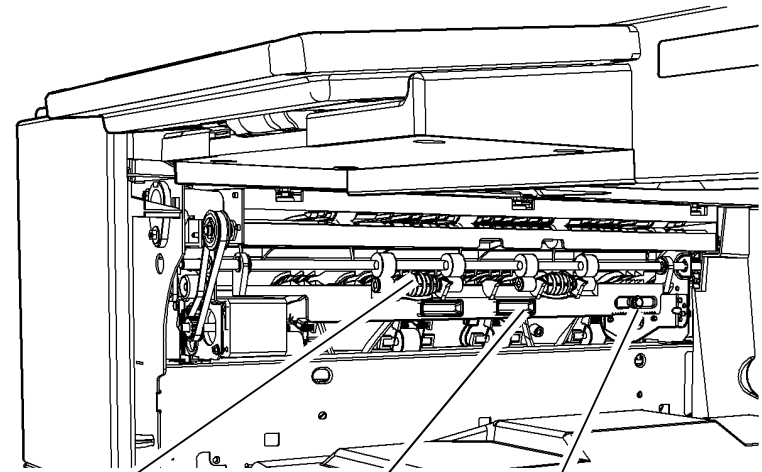
Offset shuttle.

Offset sensor, Q10-300.

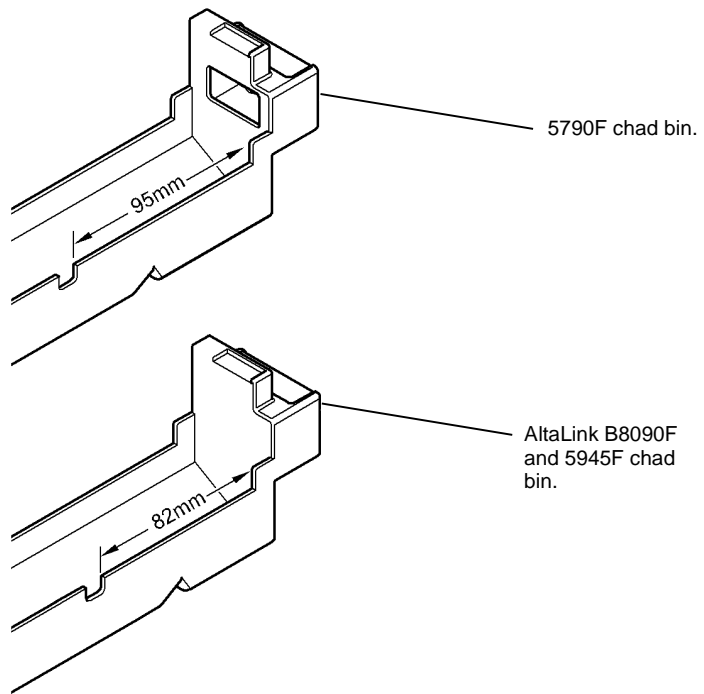
Figure 3 Chad bin differences

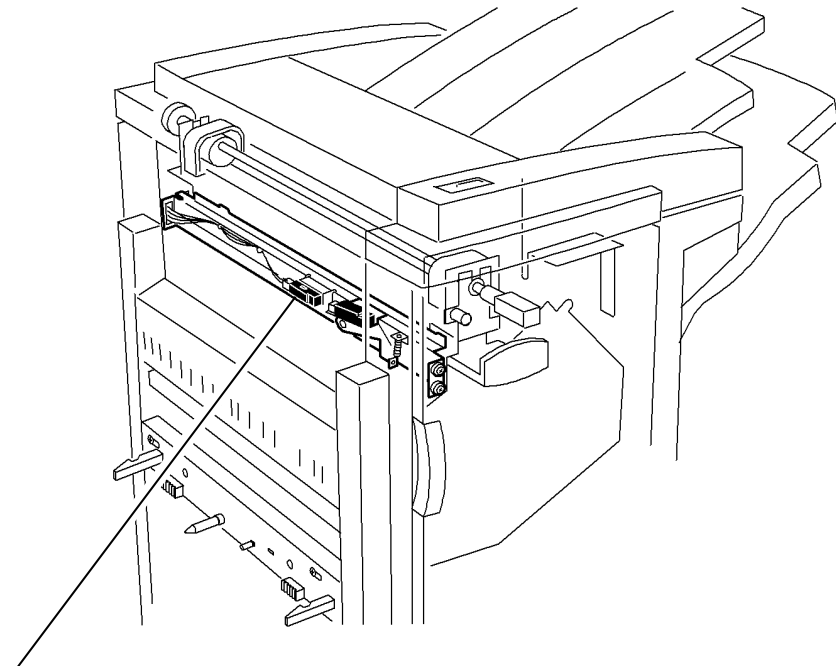
Figure 1 Component location

Punch sensor 1, Q12-078.

- Punch sensor 1, PL 12.20 Item 7.
- 2K LCSS PWB, PL 12.75 Item 1.

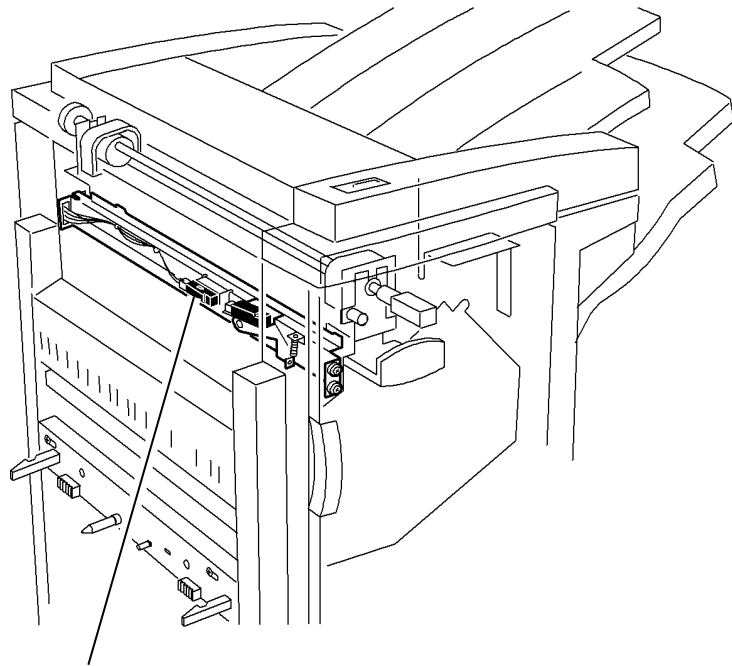
Figure 2 Component location

Punch sensor 1, Q12-078.

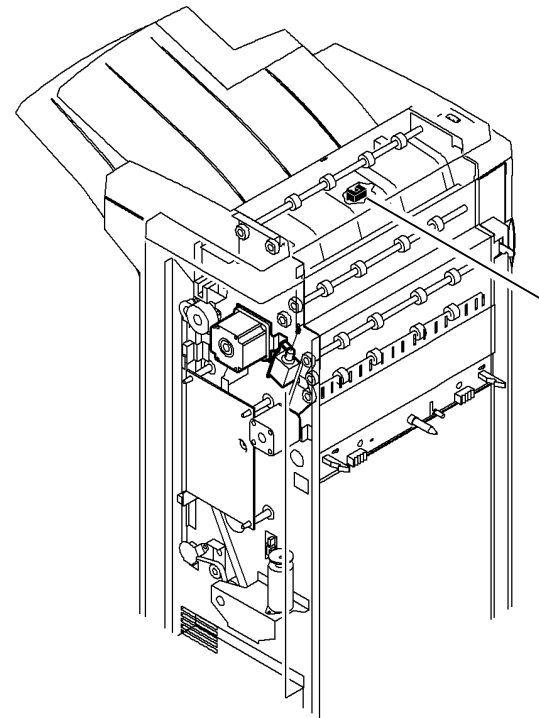
Figure 3 Component location

Top tray exit sensor, Q12-107.

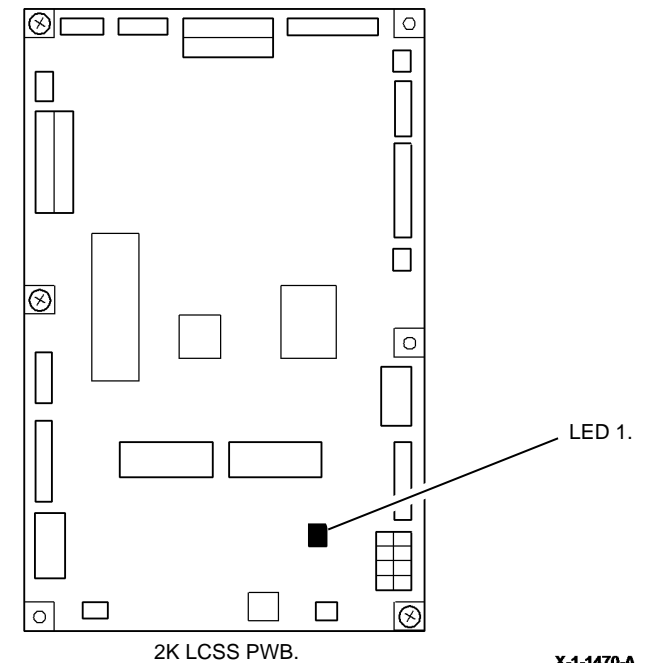
Figure 1 LCSS LED1 location

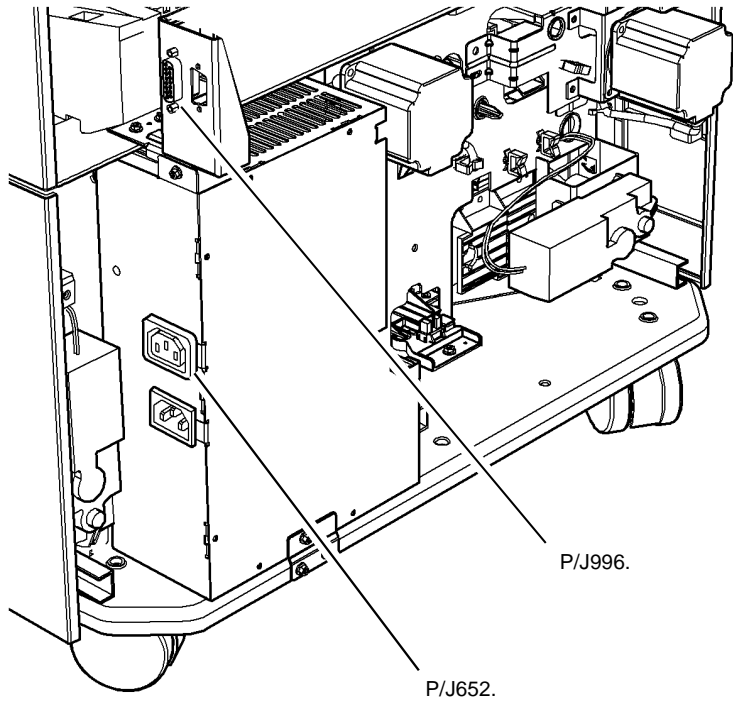
Figure 2 PJ966 and PJ652 locations

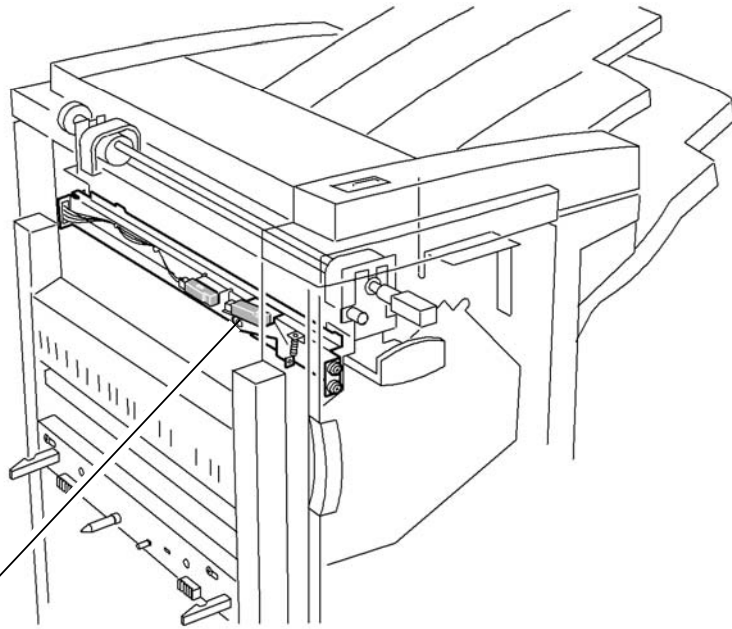
Figure 1 Component location

Chad bin level sensor, Q12-193.
