708P91368
September 2017

Xerox® AltaLink® B8090 Family Multifunction Printer Service Manual

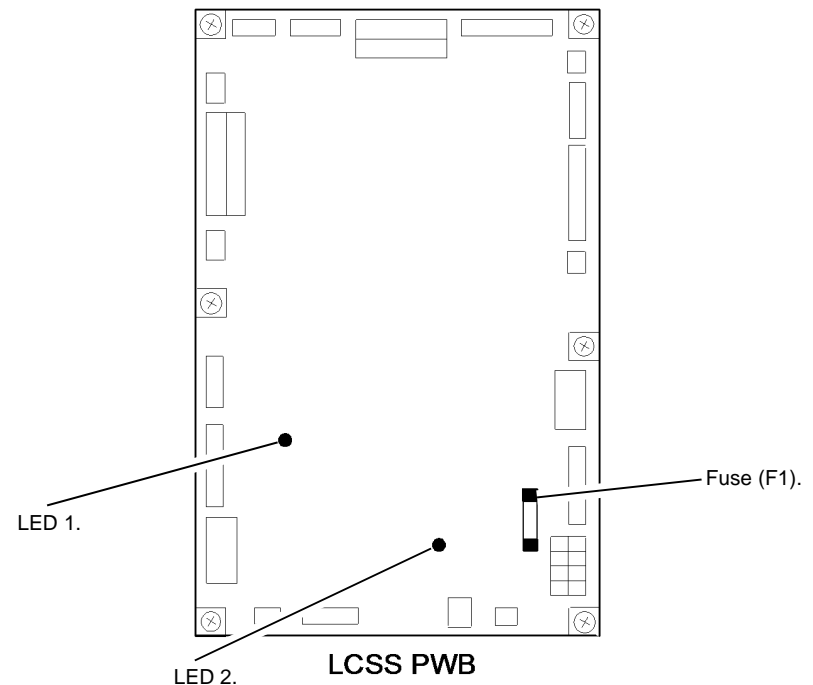
Figure 1 LED location

Remove the 2K LCSS top cover, front door cover assembly, [REP 12.1-110](#), so that the units can be viewed. Cheat the front door interlock switch and the top cover interlock switch. Check that LED 2 is illuminated. This shows that all interlocks are made. If the LED fails to illuminate, go to [312-312-00-110, 312-313-00-110 Interlocks RAP](#).

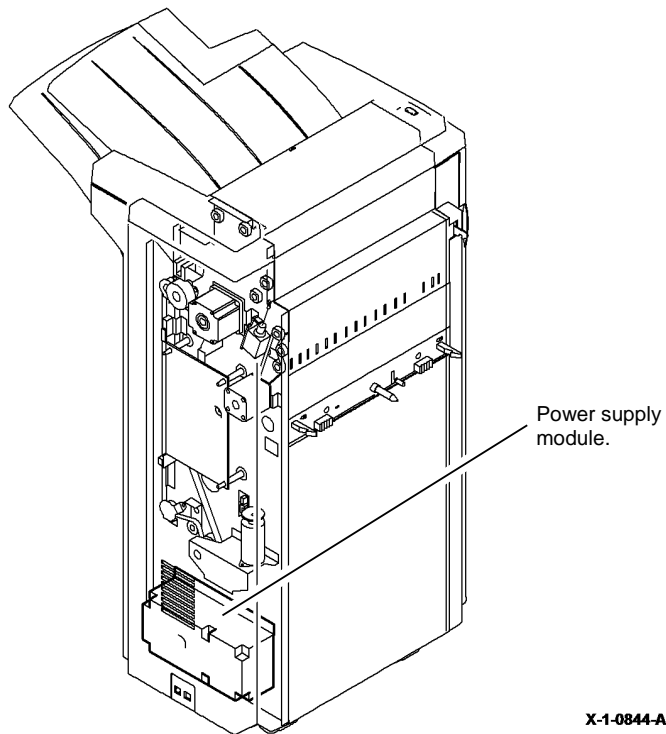
Figure 1 Component location

Refer to [Figure 1](#). Loosen the 4 screws and lift the power supply module away from the 2K LCSS frame. Go to [Flag 1](#). **ACL is available at CN1 between pins 1 and 3.**

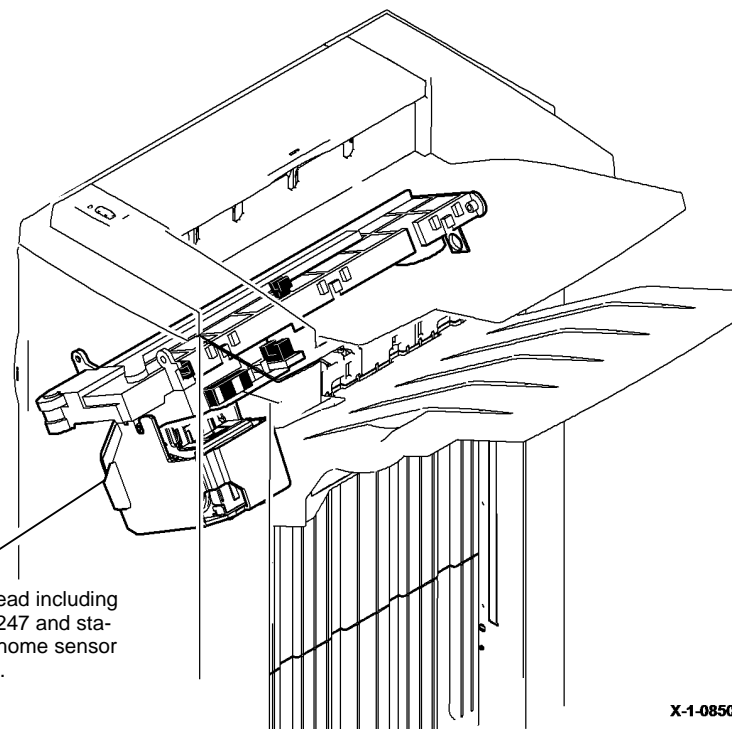
Figure 1 Component location

Staple head including MOT12-247 and stapler jaw home sensor Q12-318.

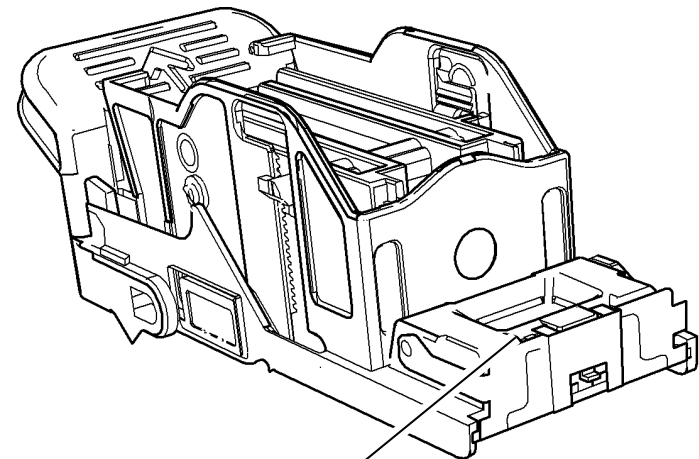
Figure 2 Staple cartridge closed

Forming plate closed.

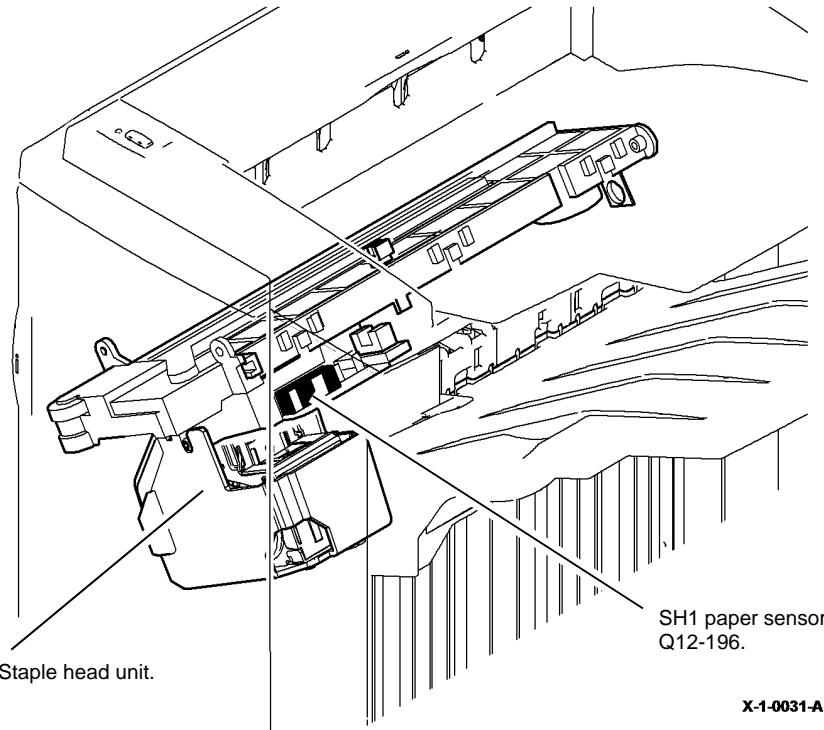
Figure 1 Component location

Staple head unit.

SH1 paper sensor
Q12-196.

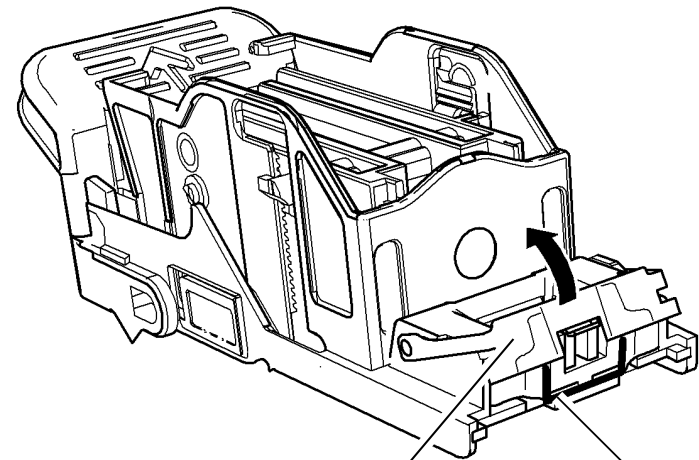
Figure 3 Staple cartridge open

Primed staples.

Forming plate open.

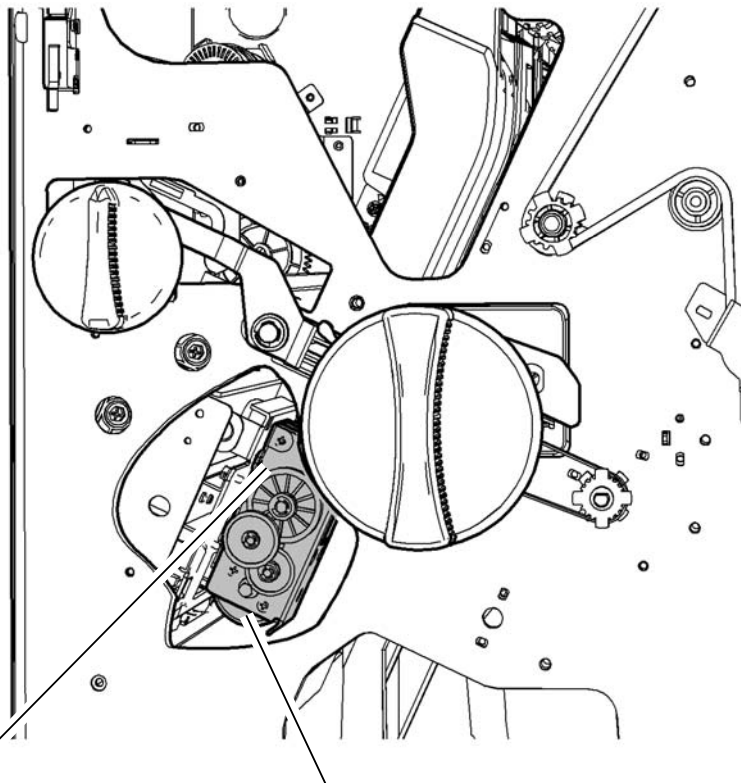
Figure 2 Component location

BM stapler jaw home sensor, Q12-411
(part of the BM staple head assembly).

BM stapler clinch motor, MOT12-437
(part of the BM staple head assembly).

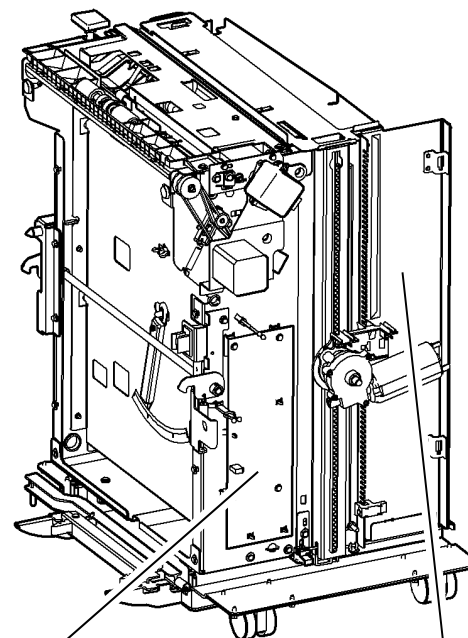
Figure 1 Component location

BM booklet tamper 1 motor,
MOT12-256.

BM tamper 1 home sensor,
Q12-205.

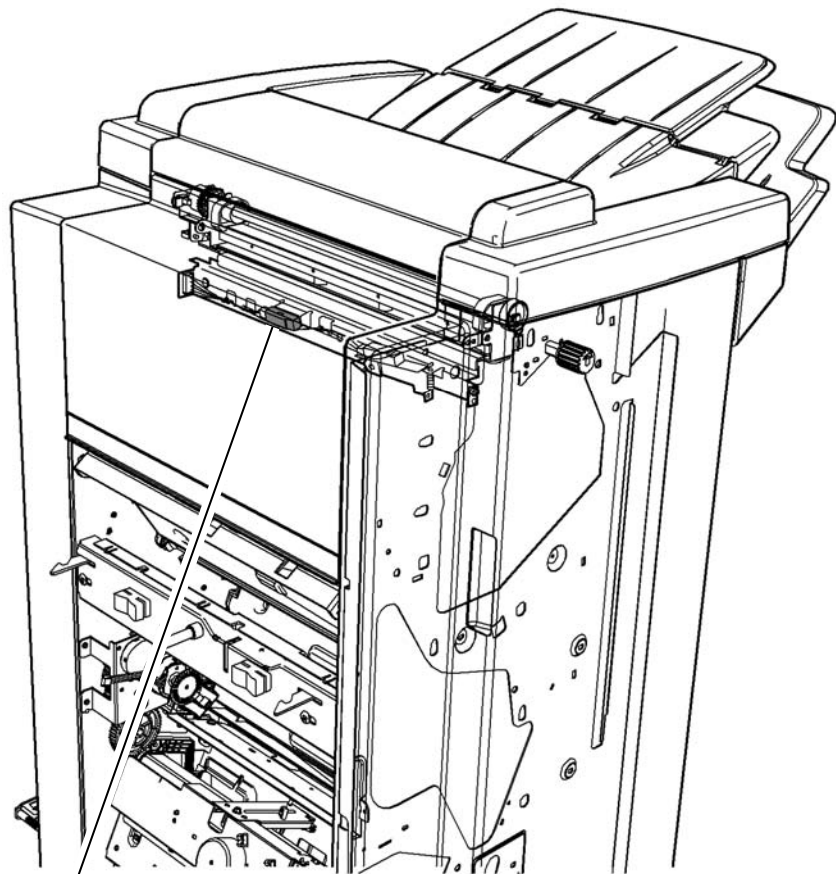
Figure 1 Component location

Punch sensor 1, Q12-078.

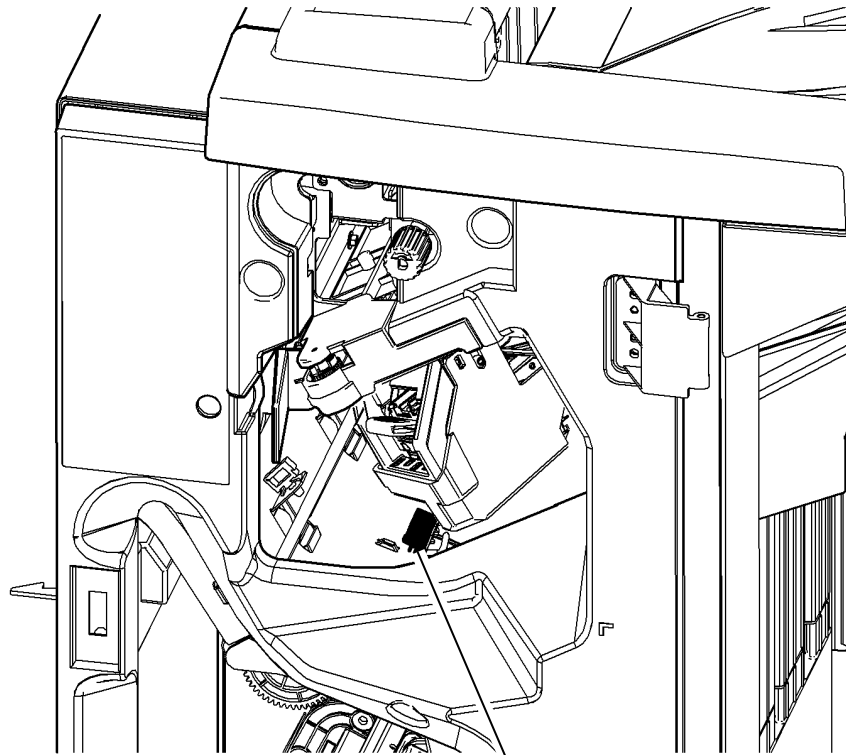
Figure 1 Component location

BM entry sensor, Q12-089.

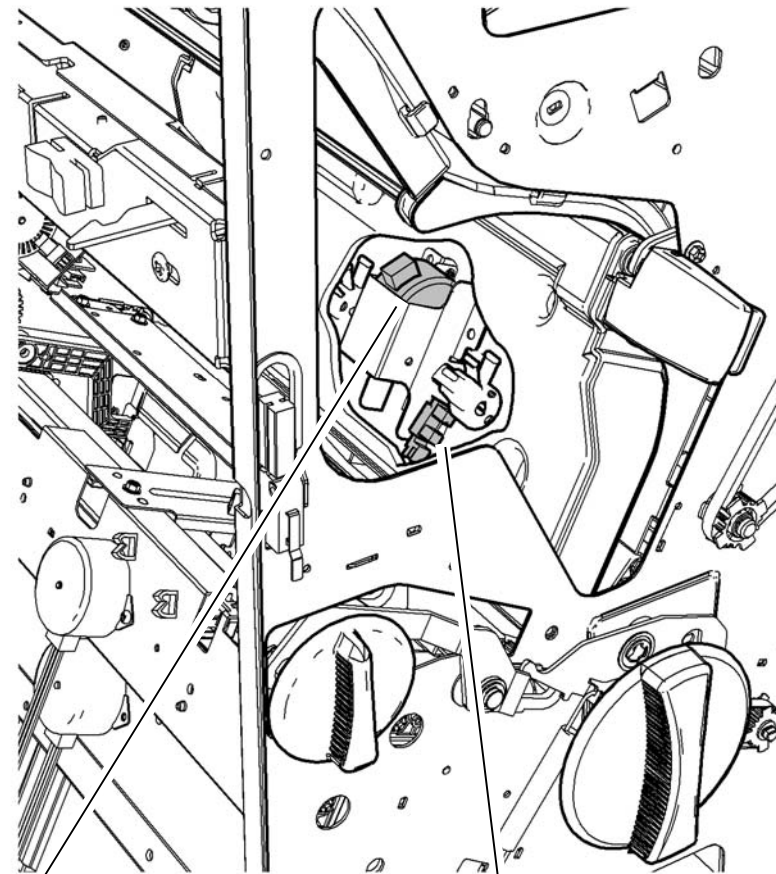
Figure 2 Component location

BM flapper motor,
MOT12-271.

BM flapper home
sensor, Q12-207.

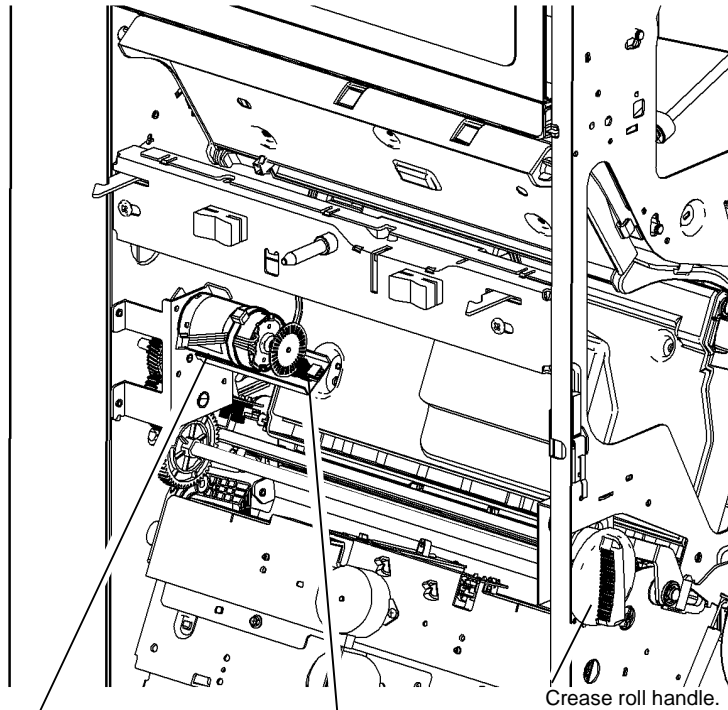
Figure 1 Component location

Crease blade motor,
MOT12-252.

Crease blade motor encoder sensor,
Q12-215.

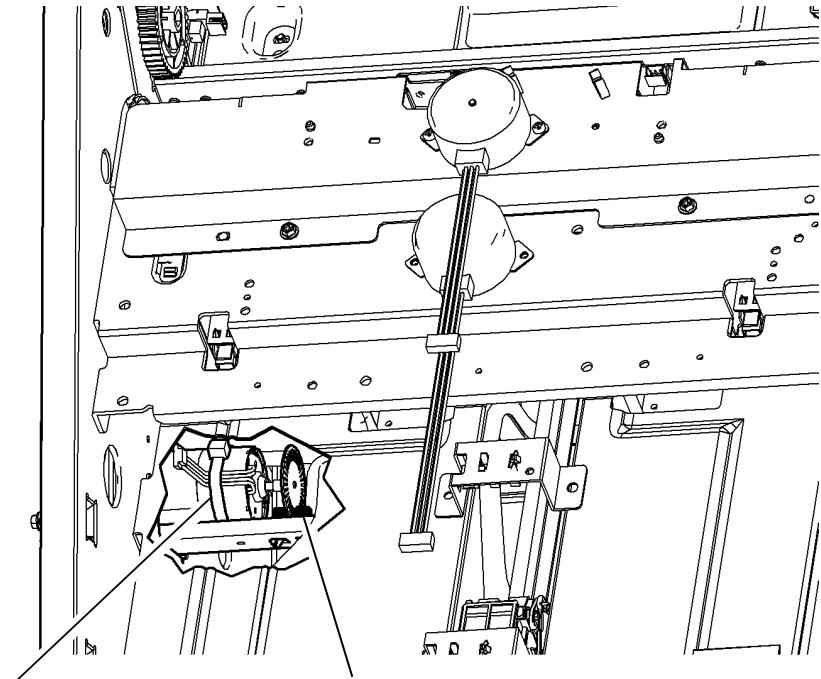
Figure 2 Component location

Crease roll motor, MOT12-253.

Crease roll motor encoder sensor, Q12-216.

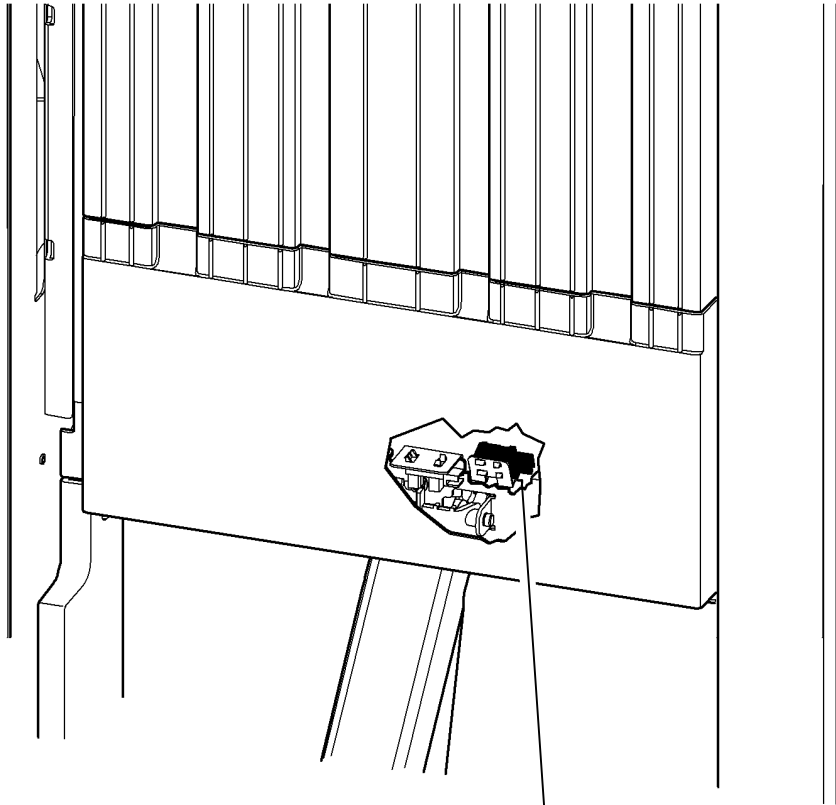
Figure 3 Component location

BM exit sensor, Q12-213.

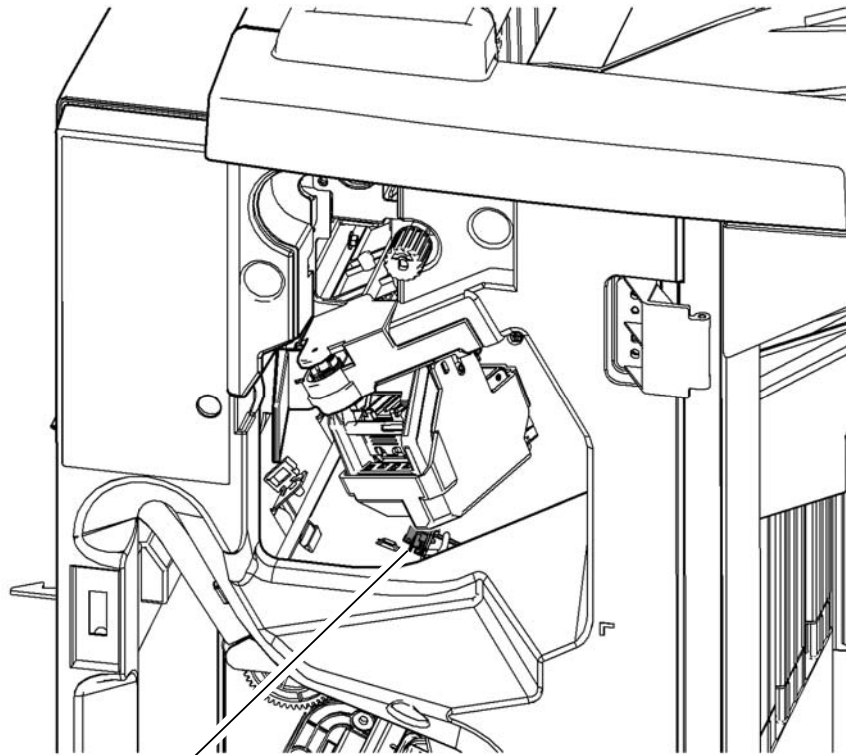
Figure 1 Component location

BM entry sensor,
Q12-089.

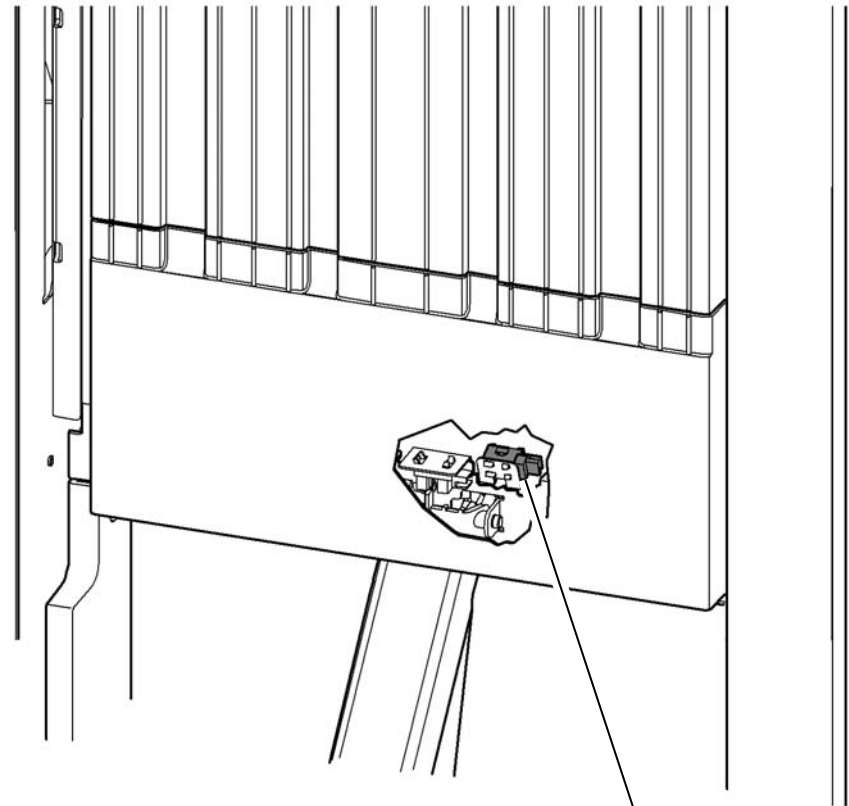
Figure 2 Component location

BM exit sensor,
Q12-213.

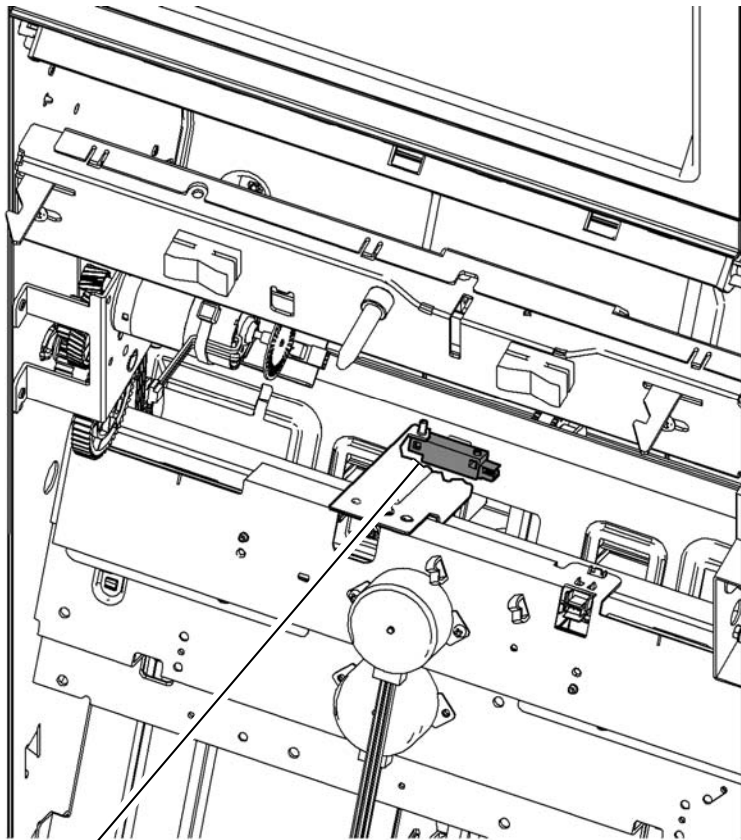
Figure 3 Component location

BM paper present sensor, Q12-170.

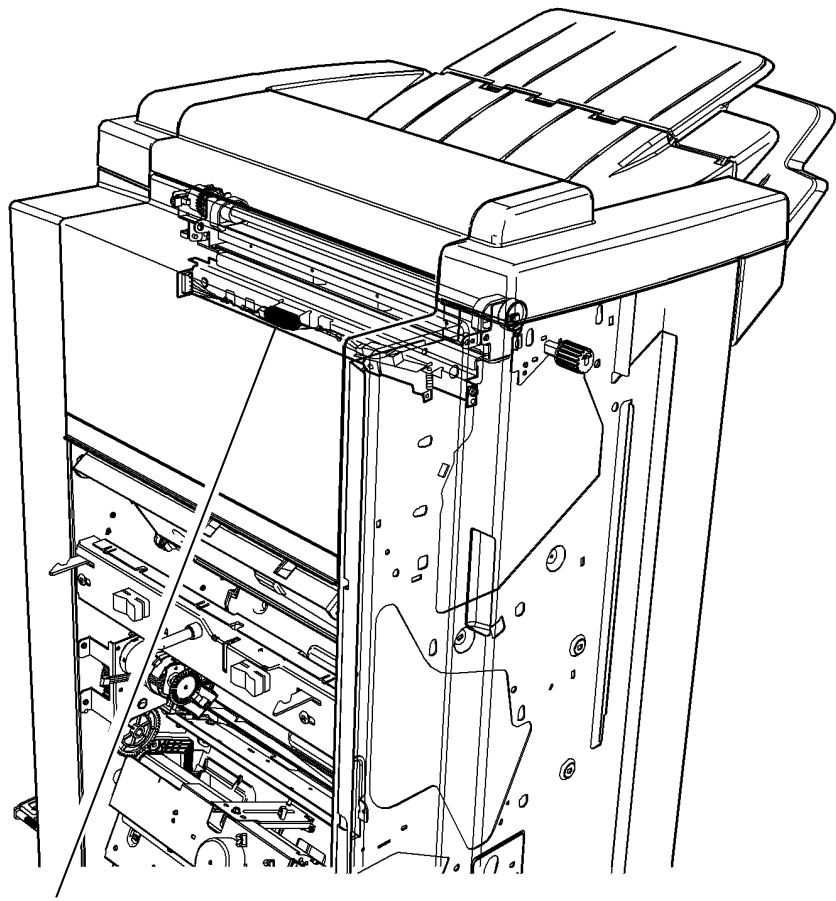
Figure 2 Component location

Punch sensor 1, Q12-078.

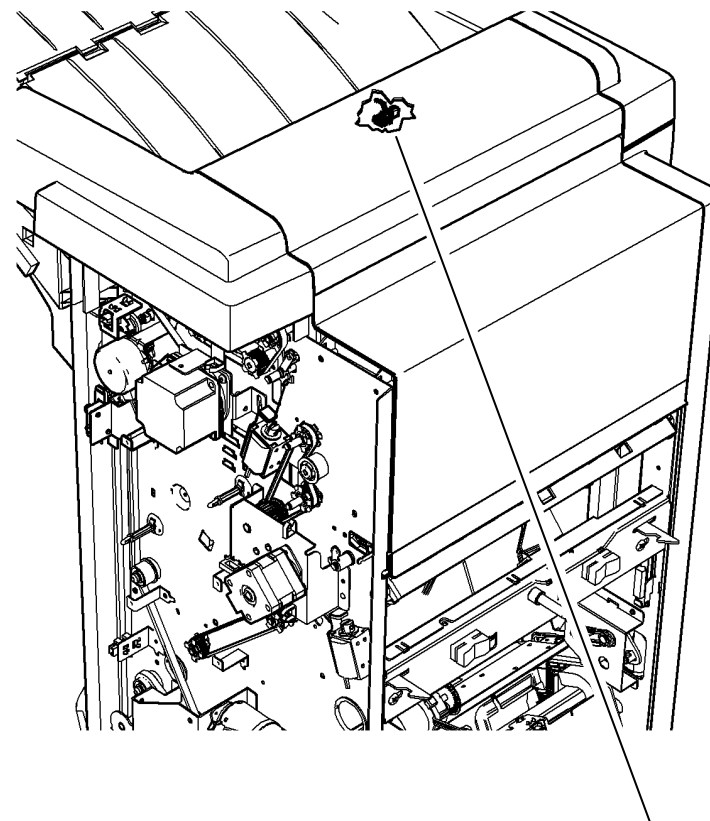
Figure 3 Component location

Top tray exit sensor, Q12-107.

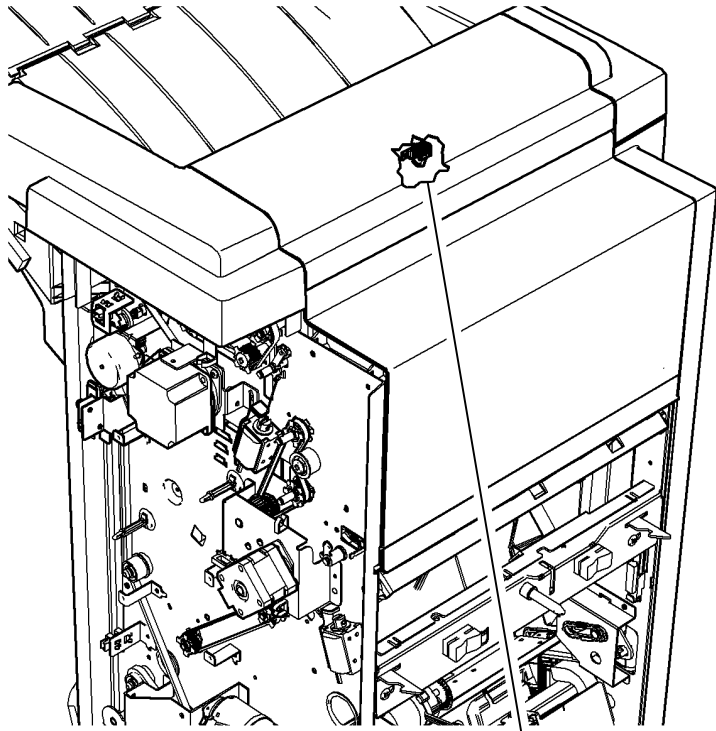
Figure 4 Component location

Compiler exit
sensor, Q12-106.

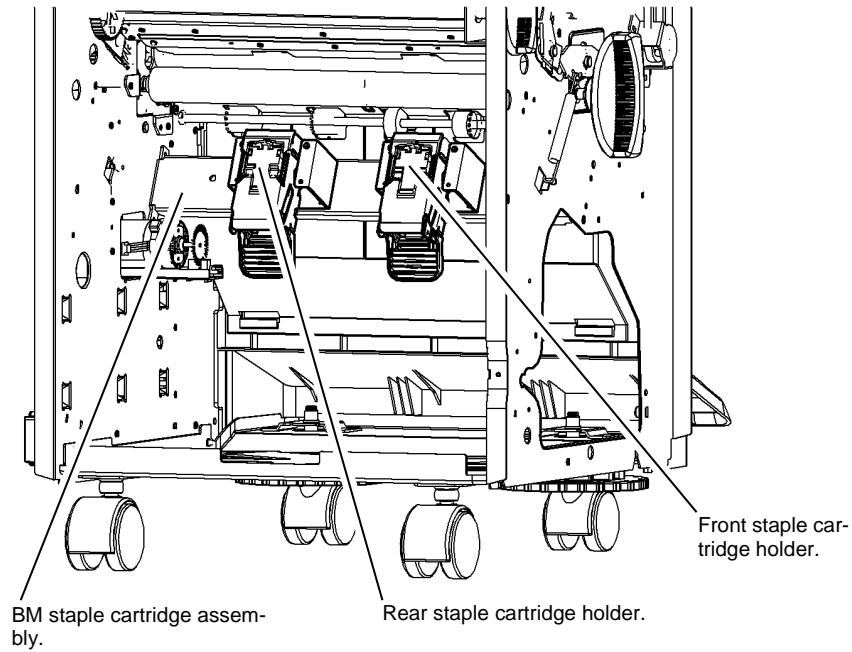
Figure 1 Component location

NOTE: The back stop assembly, BM stapler assembly and booklet tamper assembly have been removed for clarity.

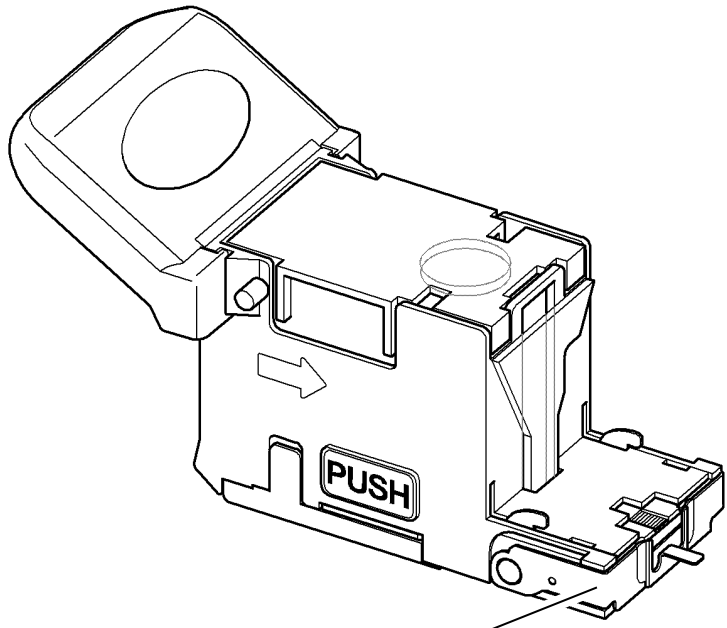
Figure 3 Staple cartridge closed

Forming plate fully closed.

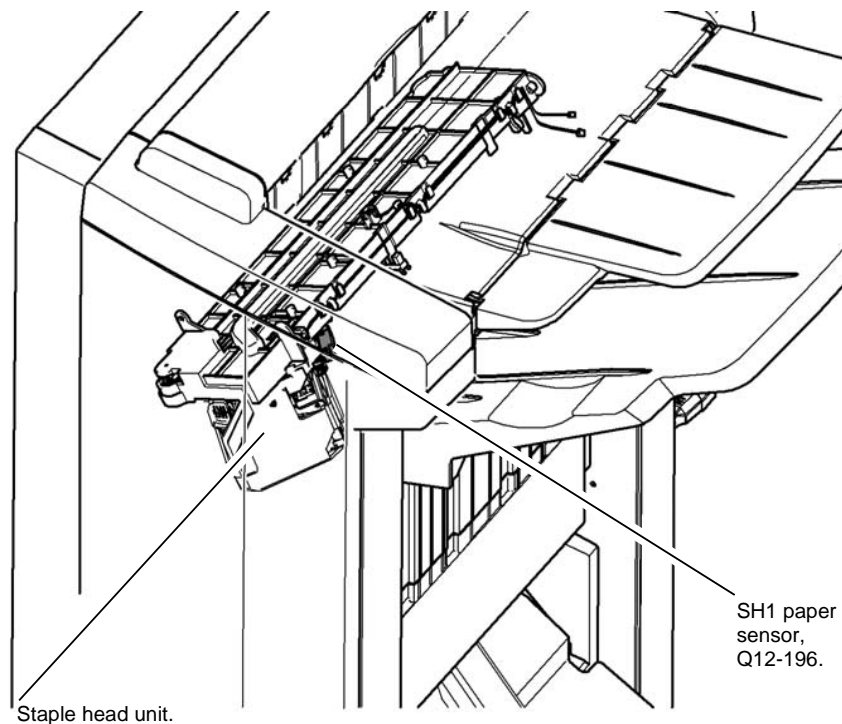
Figure 1 Component location

SH1 paper sensor,
Q12-196.

Staple head unit.

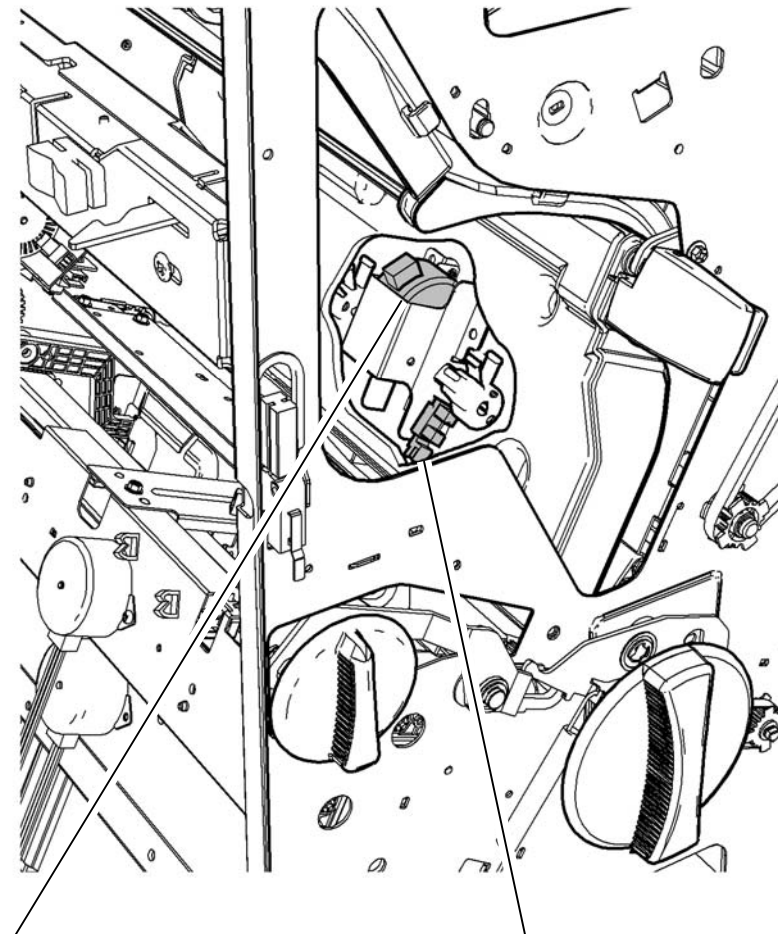
Figure 1 Component location

BM flapper motor,
MOT12-271.

Flapper home
sensor, Q12-207.

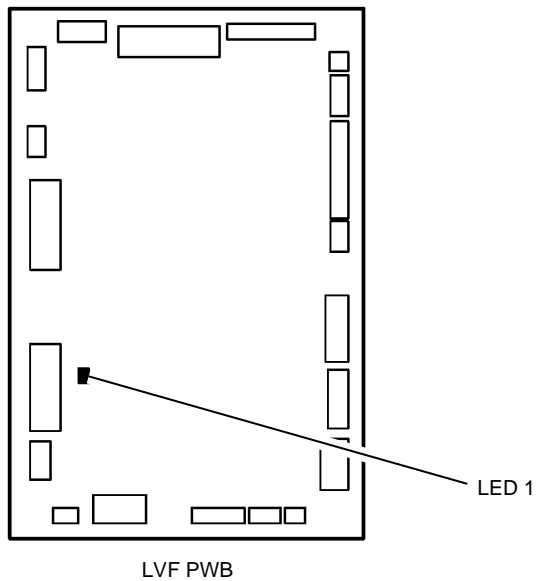
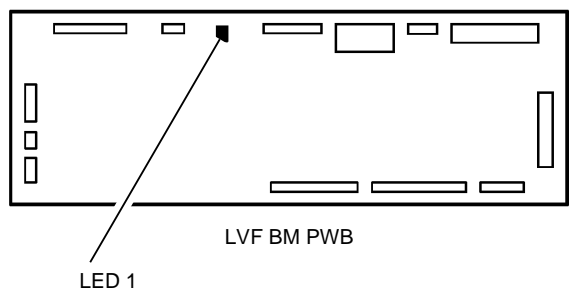
X-1-1471-A

Figure 1 LED 1 locations

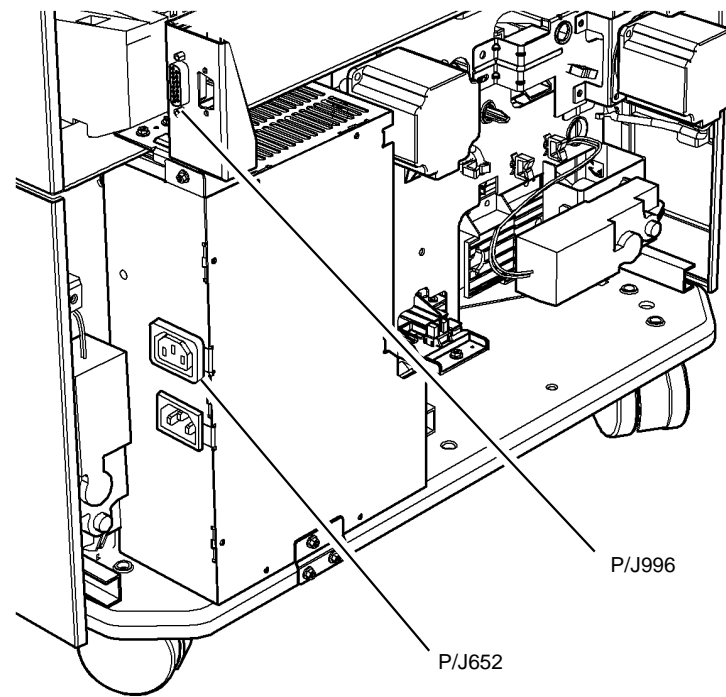
W-1-1469-A

Figure 2 P/J652 and P/J996 locations

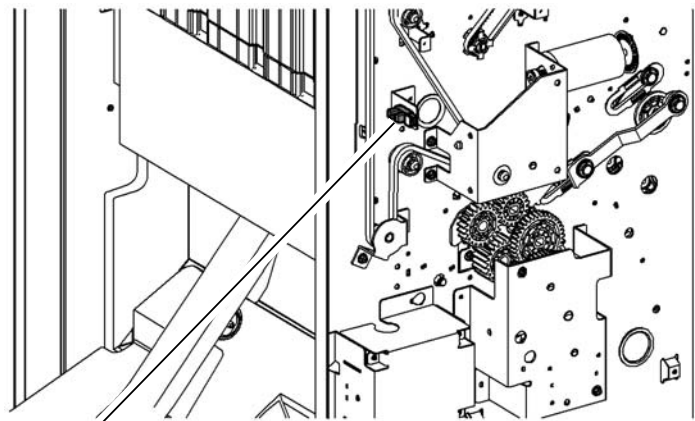
X-1-0068-A

Bin 1 90% full sensor, Q12-187.

Figure 1 Component location

- Bin 1 90% full sensor, [PL 12.340 Item 5](#).
- LVF PWB, [PL 12.425 Item 8](#).

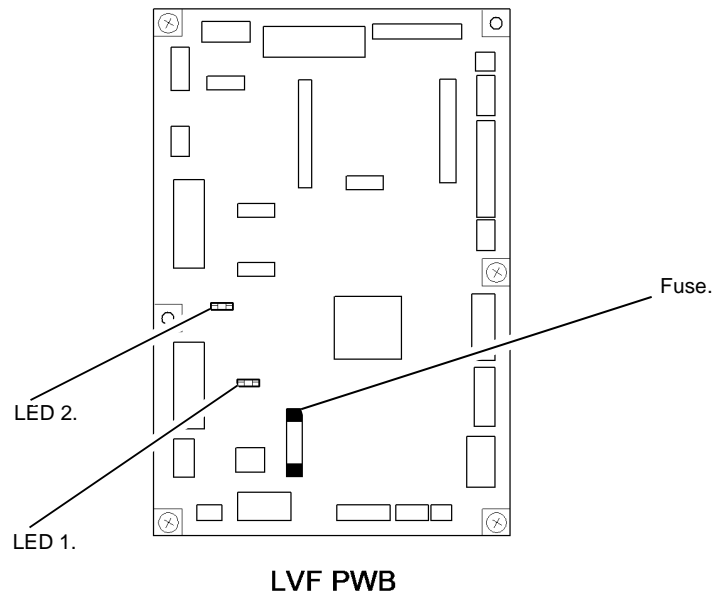
X-1-0069-A

Figure 1 LED location

Remove the LVF BM covers, [REP 12.1-150](#), so that the units can be viewed. Cheat the front door interlock switch and the top cover interlock switch. Check that LED 2 is illuminated. This shows that all interlocks are made. If the LED fails to illuminate, go to [312-312-00-150, 312-313-00-150 Interlocks RAP](#).

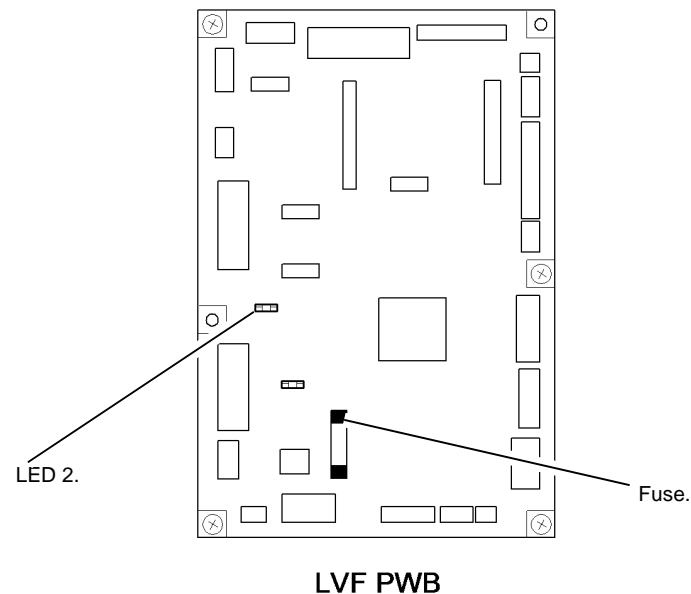
X-1-0954-A

LVF PWB

Figure 1 LED location

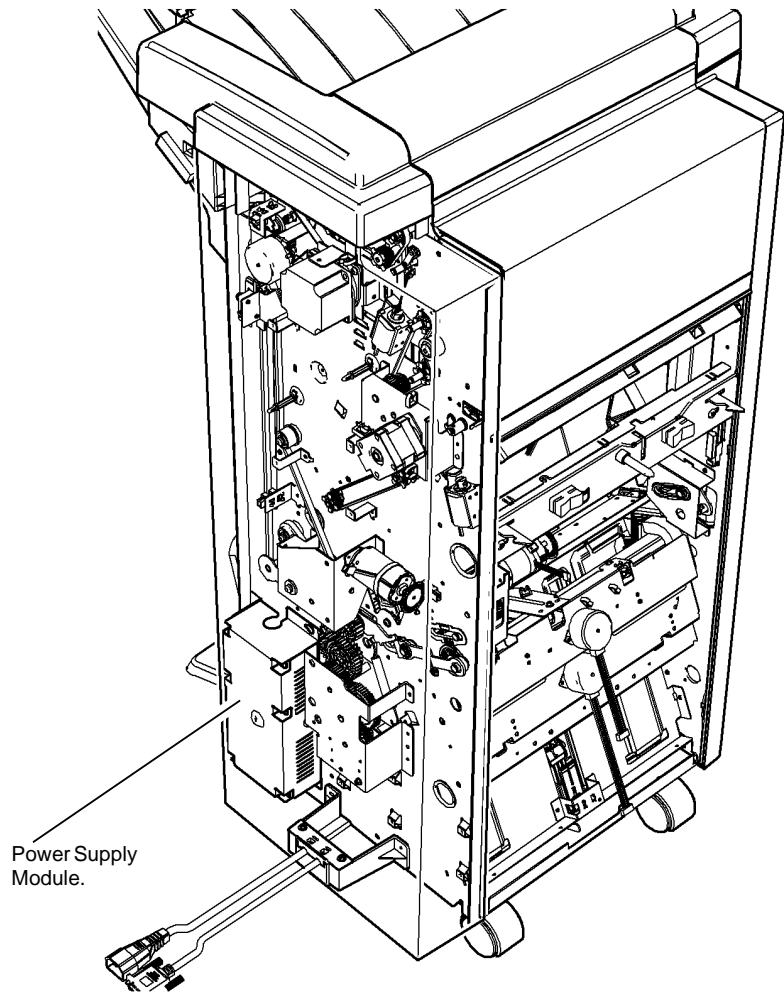
X-1-0070-A

Figure 2 Component location

Figure 2. Loosen the 4 screws and lift the power supply module away from the LVF BM frame. Go to Flag 1. **ACL is available at CN1 between pins 1 and 3.**

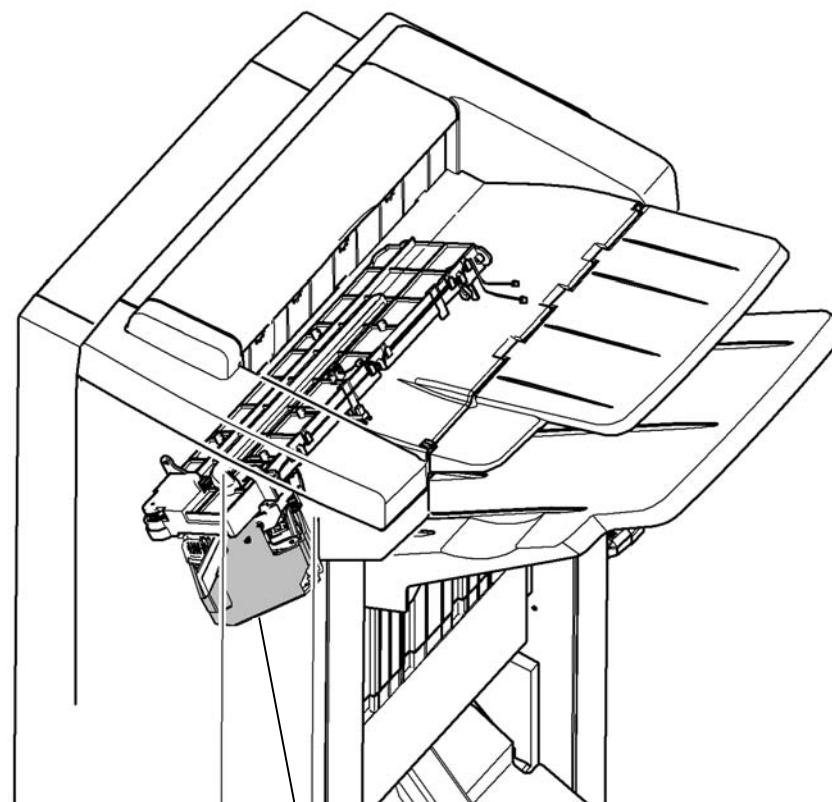
X-1-0040-A

Staple head including MOT12-247 and stapler jaw home sensor, Q12-318.

Figure 1 Component location

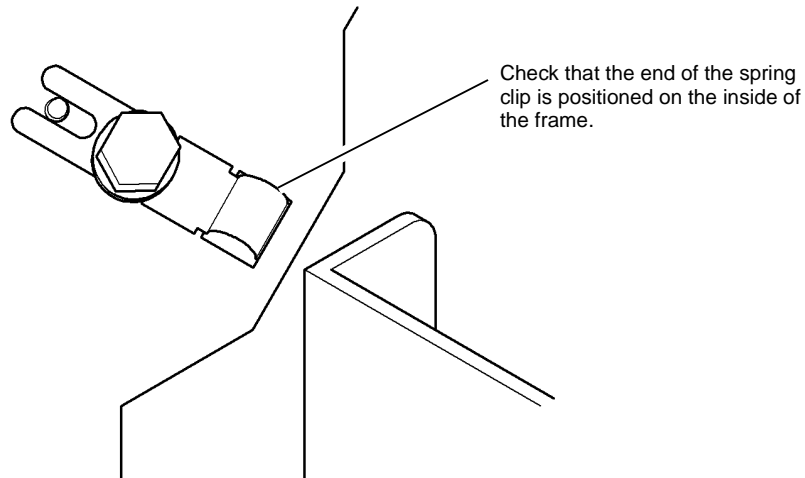
Figure 1 Position of the spring clip

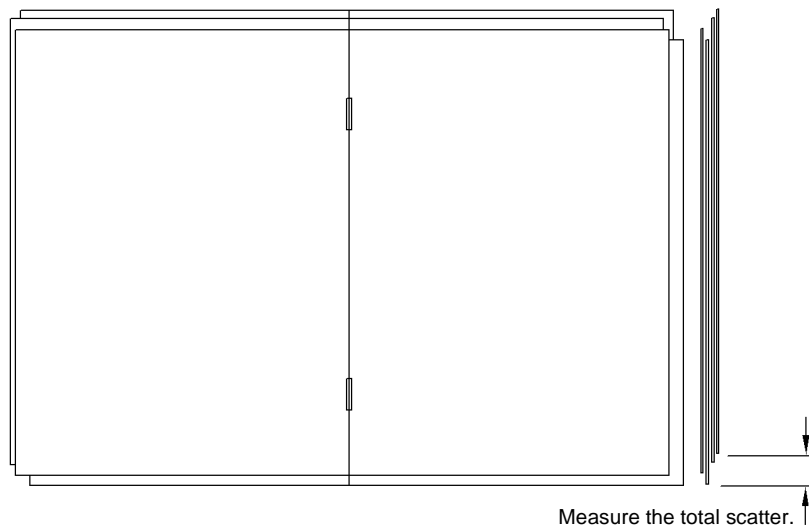
Figure 1 Top and bottom alignment

Open out the booklet at the centre page and press it onto a flat surface. Measure the mis-alignment of the top and bottom edges of the booklet, [Figure 1](#).

If the top and bottom edge alignment does not conform to the specification in [Table 2](#), check the operation of the BM tampers. Refer to [312-066-00-150](#), [312-384-00-150](#) Booklet Tamper 1 Move Failure RAP.

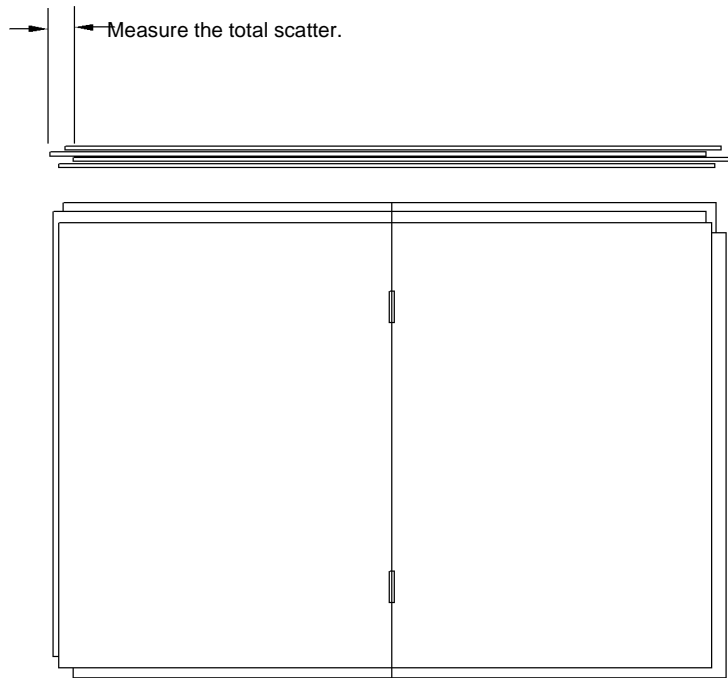
X-1-1346-A

Figure 2 Open side edge alignment

Open out the booklet at the centre page and press it onto a flat surface. Measure the mis-alignment of the open side edges of the booklet, [Figure 2](#).

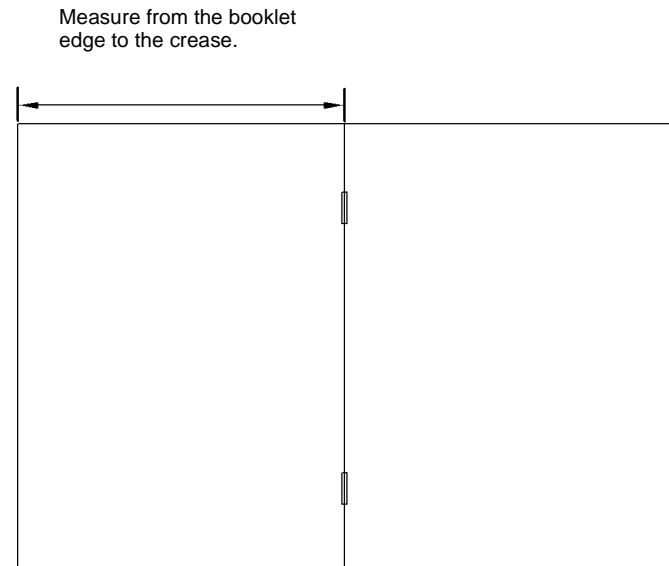
X-1-1346-A

Figure 3 Booklet skew

Open out the booklet at the centre page and press it onto a flat surface. Measure the position of booklet crease, [Figure 3](#).

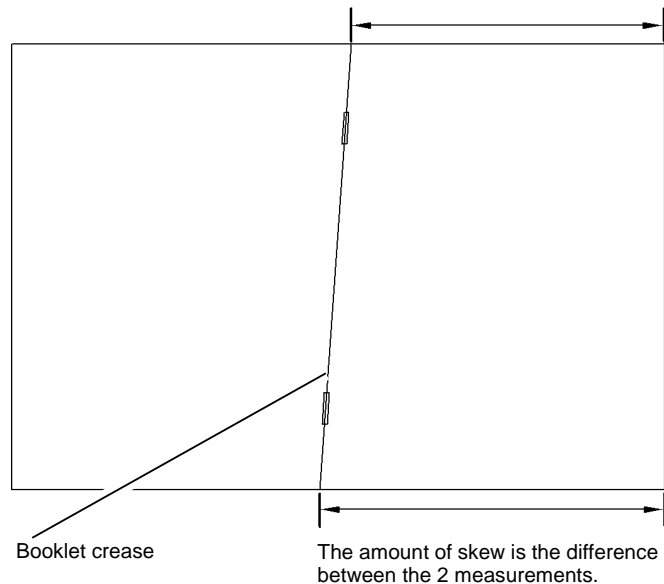
X-1-1347-A

Figure 4 Booklet crease skew

Open out the booklet at the centre page and press it onto a flat surface. Measure the mis-alignment of the open side edges of the booklet, [Figure 4](#).

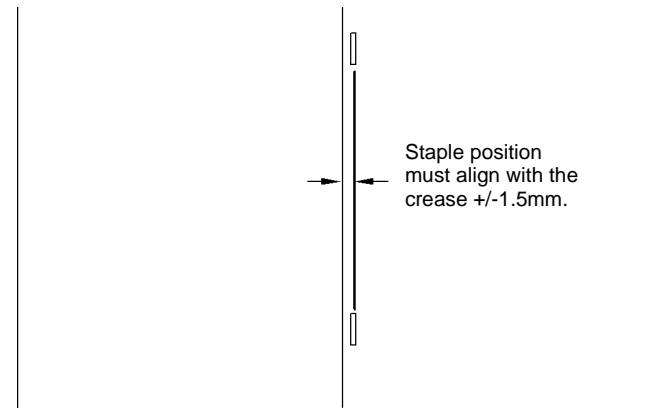
Figure 5 Booklet staple position

Open out the booklet at the centre page and press it down onto a flat surface. Measure the position of the booklet staple from the crease line, [Figure 5](#).

If the booklet staple position does not conform to the specification in [Figure 5](#), perform [ADJ 12.5-150 Booklet Staple Position](#).

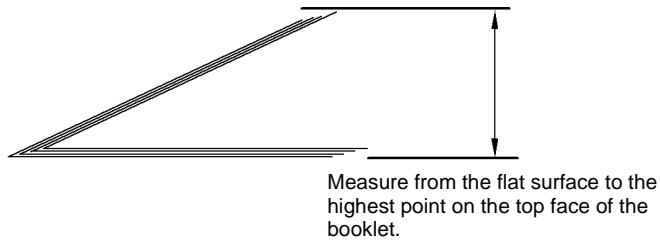
X-1-1350-A

Figure 6 Booklet creasing

Place the folded booklet onto a flat surface. Measure the maximum open dimension of the booklets within 20 seconds of being formed, [Figure 6](#).

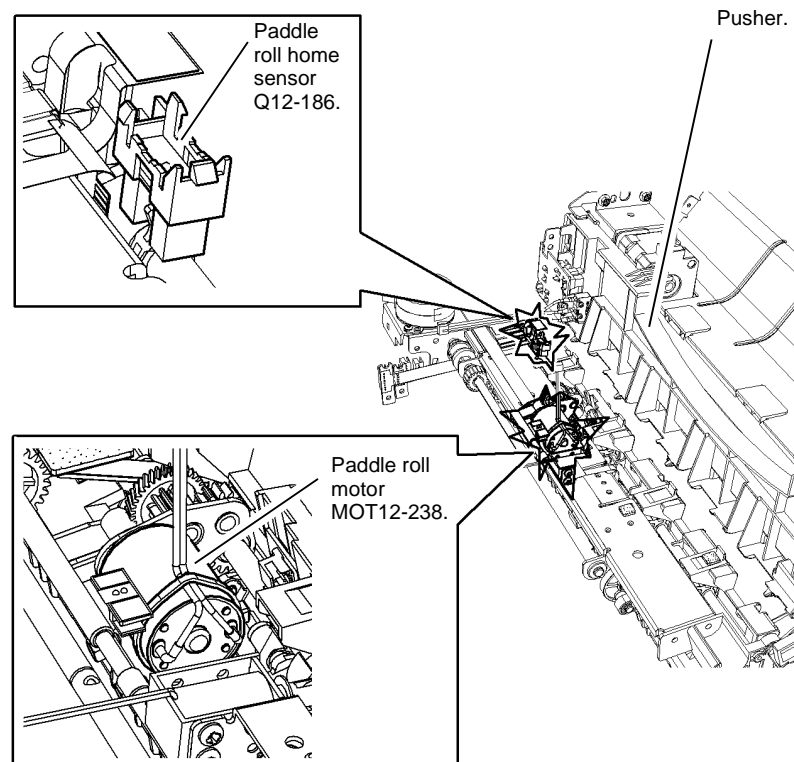
X-1-0073-A

Figure 1 Components

- Paddle unit, **PL 12.115** Item 2.
- HVF PWB, **PL 12.140** Item 2.

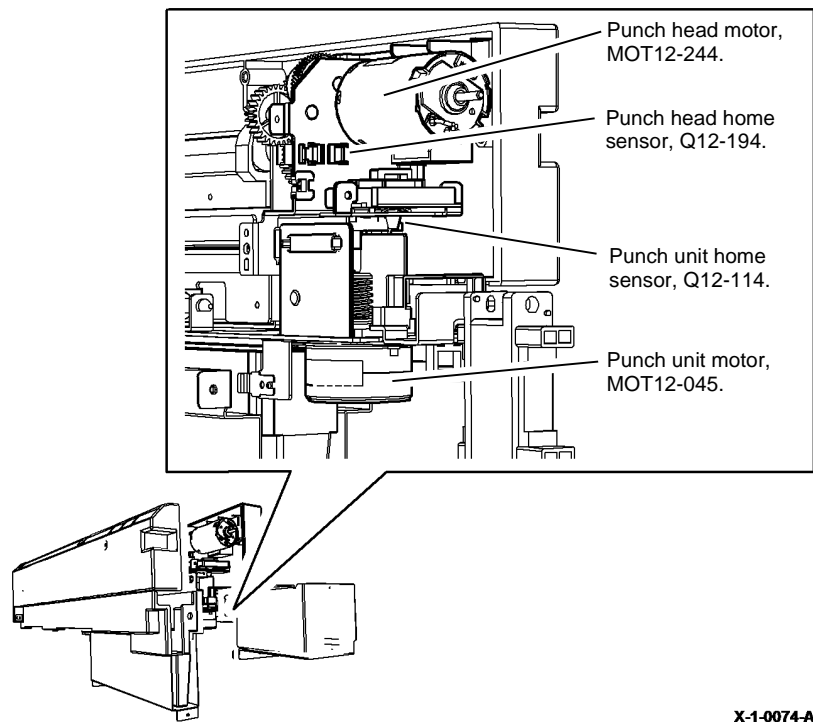
X-1-0074-A

Figure 1 Component location

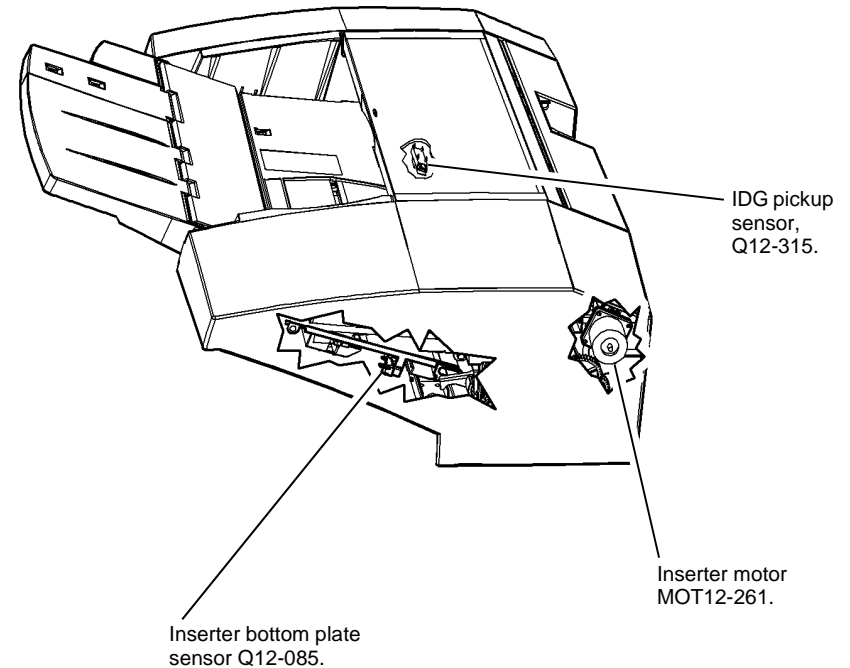
X-1-0821-A

Figure 1 Component location

- Top cover door assembly, PL 12.310 Item 20.
- Inserter PWB, PL 12.310 Item 9.
- HVF PWB, PL 12.140 Item 2.
