708P91368
September 2017

Xerox® AltaLink® B8090 Family Multifunction Printer Service Manual

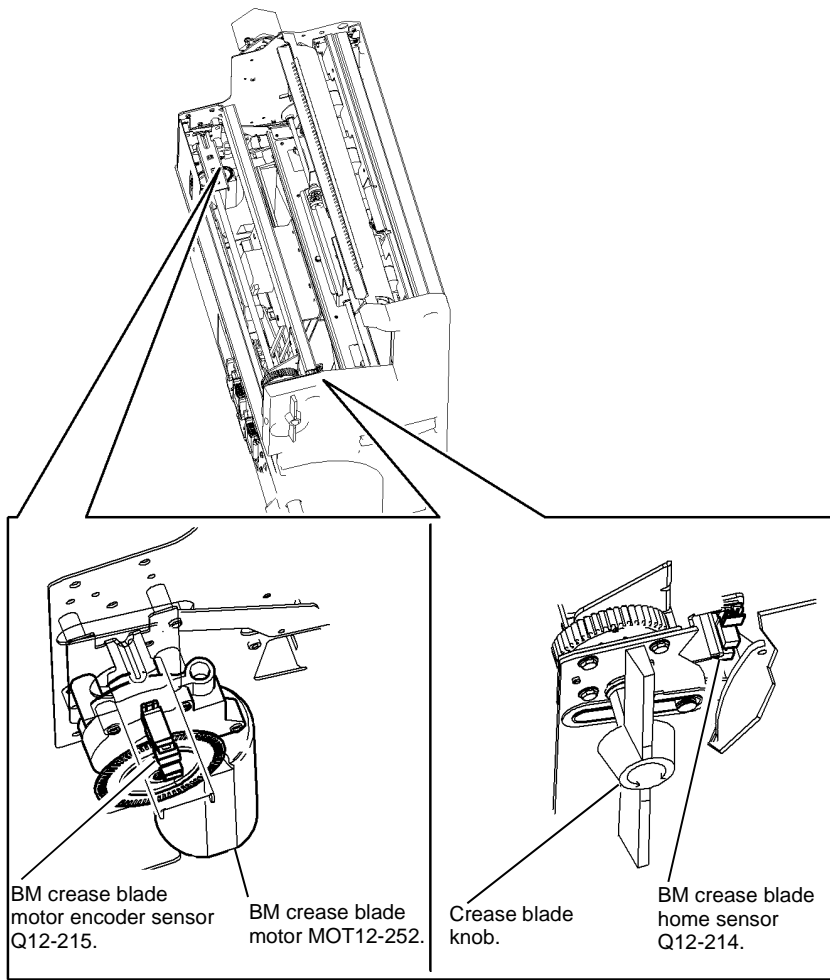
X-1-0197-A

Figure 1 Component location

- [BM crease blade motor assembly](#), [PL 12.170 Item 3](#).
- [BM PWB](#), [PL 12.175 Item 10](#).

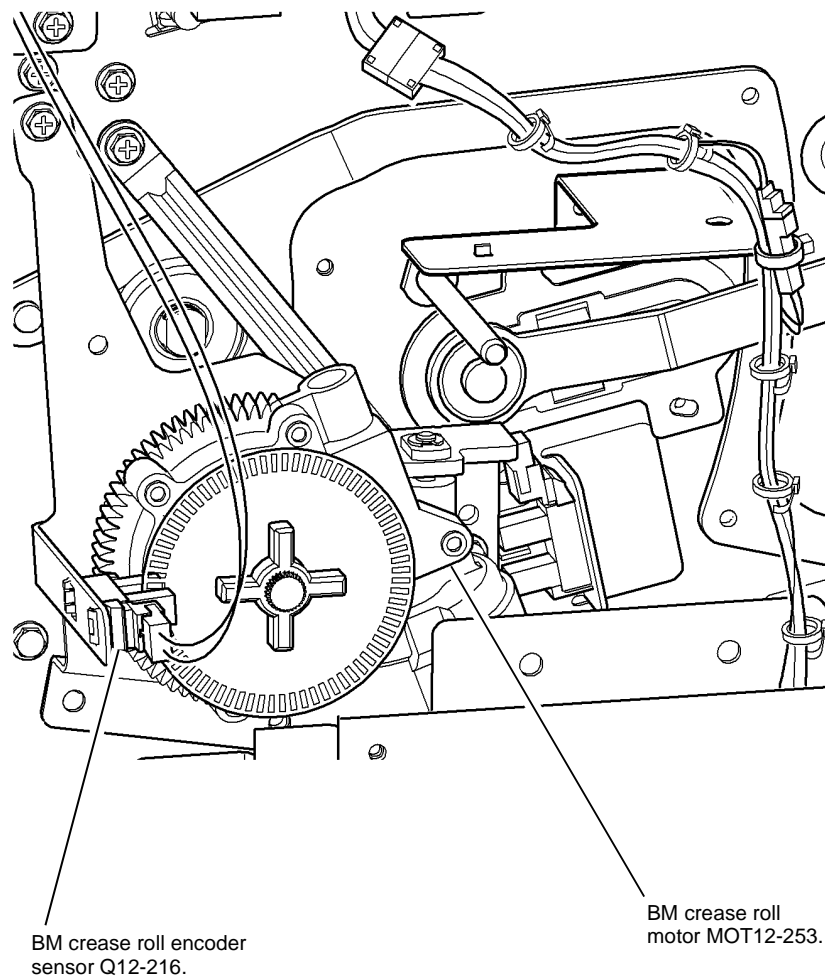
X-1-0823-A

Figure 1 Component location

- BM crease roll motor encoder sensor, PL 12.175 Item 9.
- BM crease roll motor, PL 12.175 Item 12.
- BM PWB, PL 12.175 Item 10.

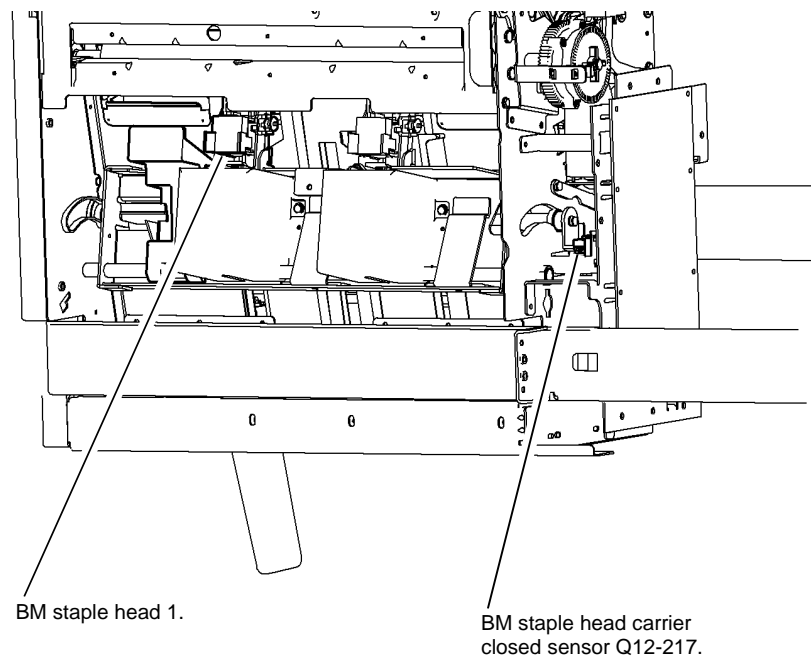
X-1-0824-A

Figure 1 Component location

- BM staple head 1, [PL 12.185 Item 7](#).
- BM PWB, [PL 12.175 Item 10](#).

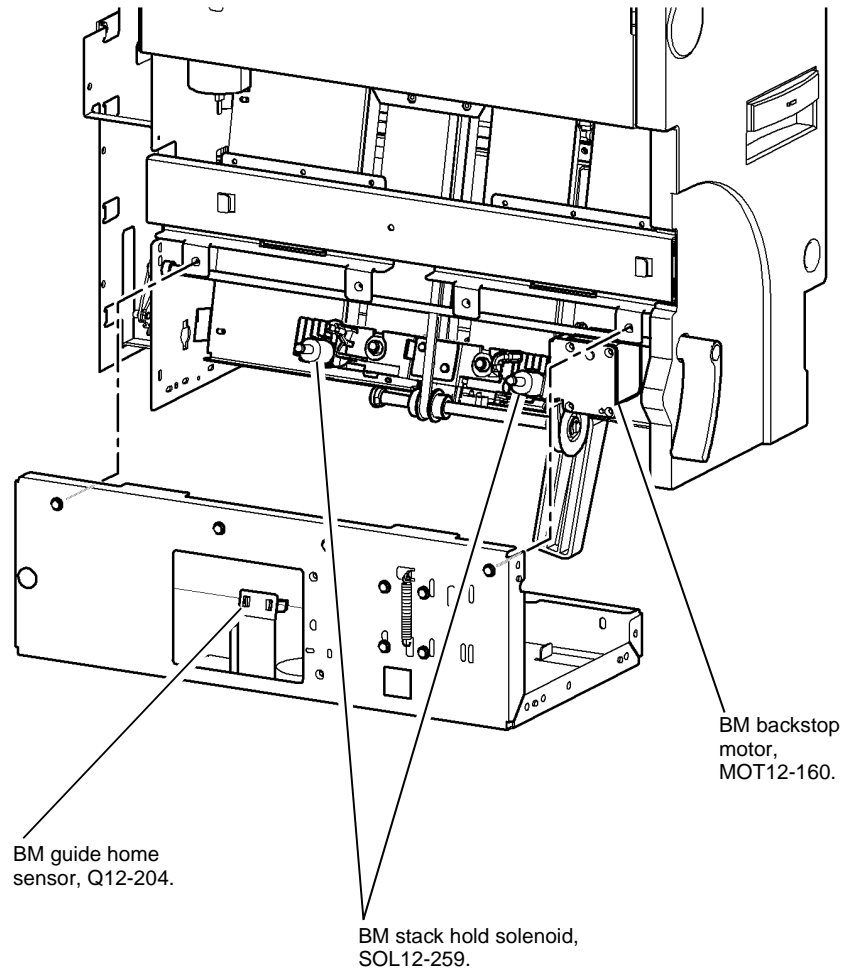
X-1-0825-A

BM guide home sensor, Q12-204.

BM stack hold solenoid, SOL12-259.

Figure 1 Component location

- BM guide home sensor, [PL 12.160 Item 18](#).
- BM backstop motor, [PL 12.160 Item 4](#).
- BM PWB, [PL 12.175 Item 10](#).

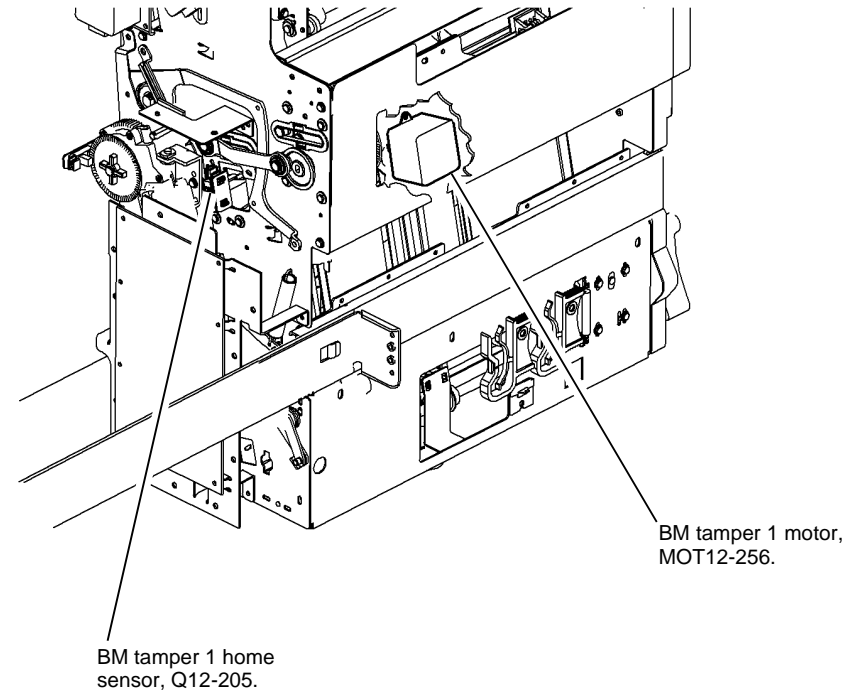
X-1-0826-A

Figure 1 Component location

- BM tamper 1 home sensor, [PL 12.155](#) [Item 1](#).
- BM tamper 1 motor, [PL 12.155](#) [Item 3](#).
- BM PWB, [PL 12.175](#) [Item 10](#).

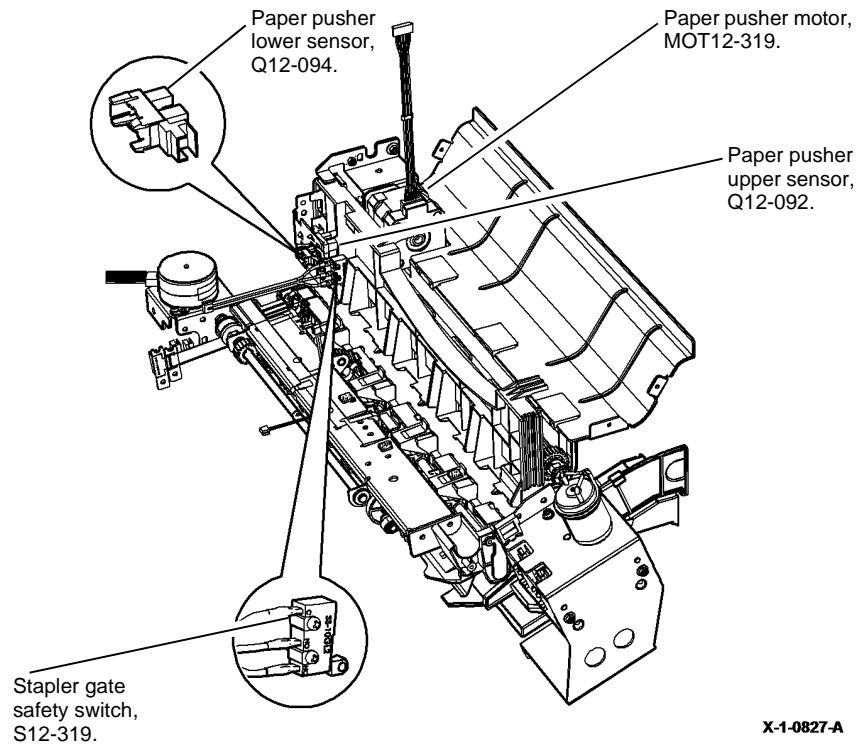
X-1-0827-A

Figure 1 Component location

- Paper pusher upper sensor, [PL 12.115 Item 16](#).
- Paper pusher lower sensor, [PL 12.115 Item 16](#).
- Paper pusher motor assembly, [PL 12.115 Item 13](#).
- Sensor assembly, [PL 12.115 Item 22](#).
- HVF PWB, [PL 12.140 Item 2](#).

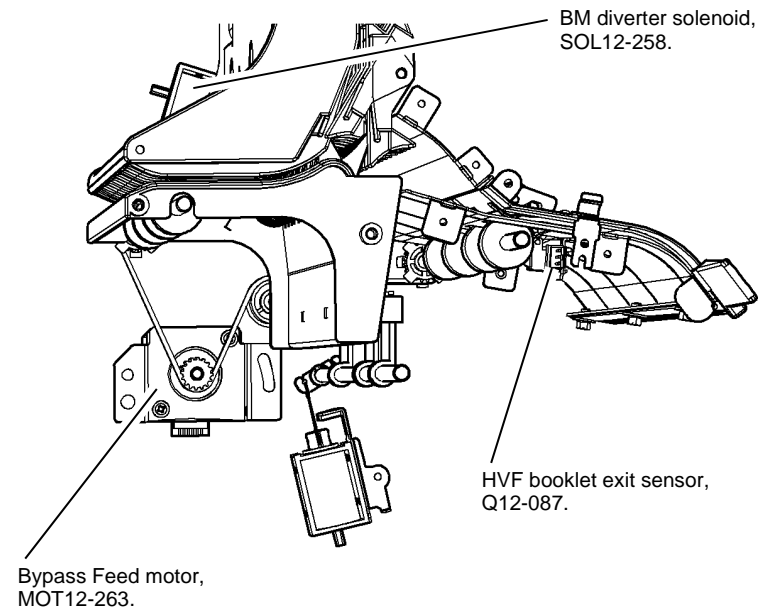
X-1-0075-A

Figure 1 Component location

- HVF booklet exit sensor, [PL 12.135](#) [Item 3](#).
- BM diverter solenoid, [PL 12.120](#) [Item 4](#).
- BM diverter gate, [PL 12.125](#) [Item 9](#).
- BM compiler motor, [PL 12.175](#) [Item 1](#).
- Bypass Feed motor, [PL 12.120](#) [Item 2](#).
- HVF PWB, [PL 12.140](#) [Item 2](#).

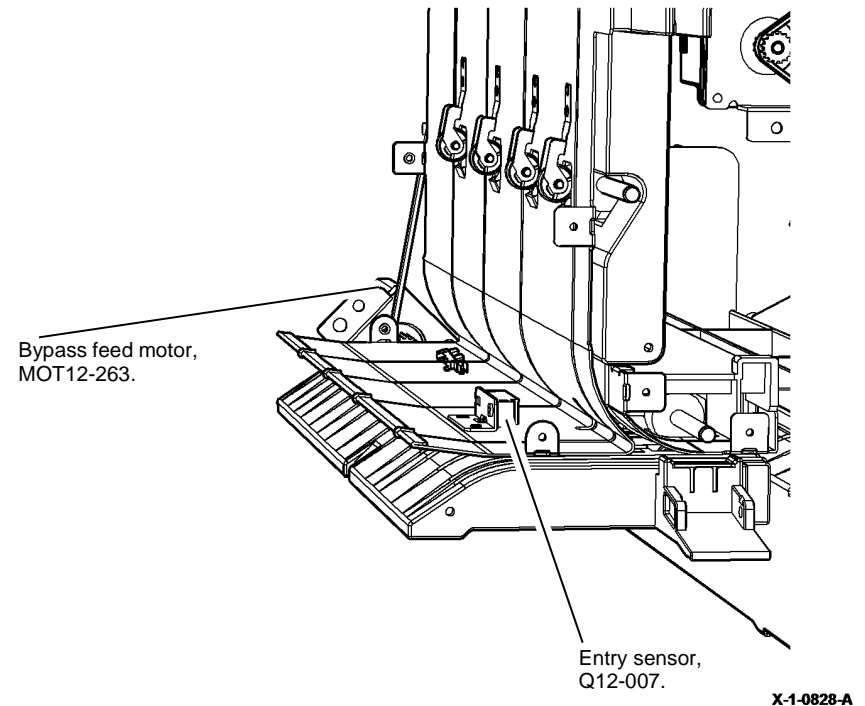
Figure 1 Component location

- Entry sensor, [PL 12.135](#) Item 2.
- Bypass feed motor, [PL 12.120](#) Item 2.
- HVF PWB, [PL 12.140](#) Item 2.

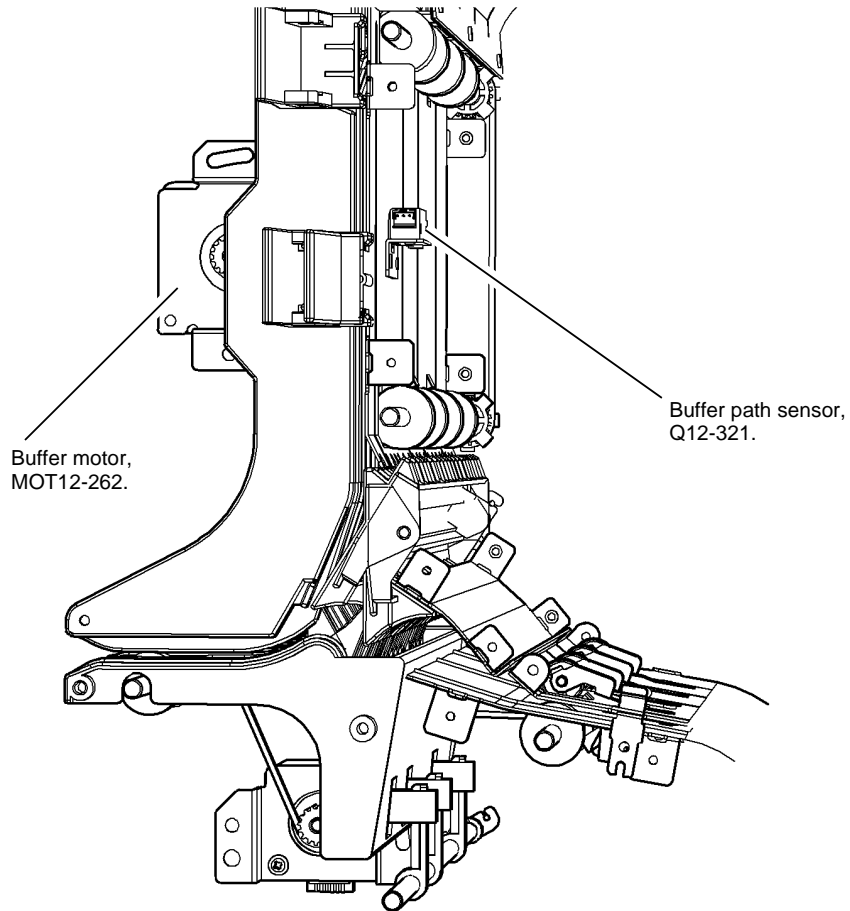
X-1-0829-A

Figure 1 Component location

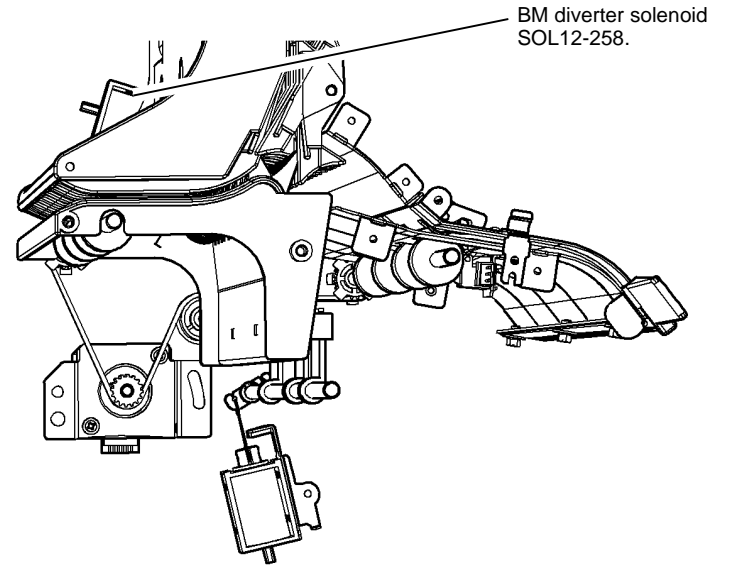
X-1-0905-A

Figure 2 Component location

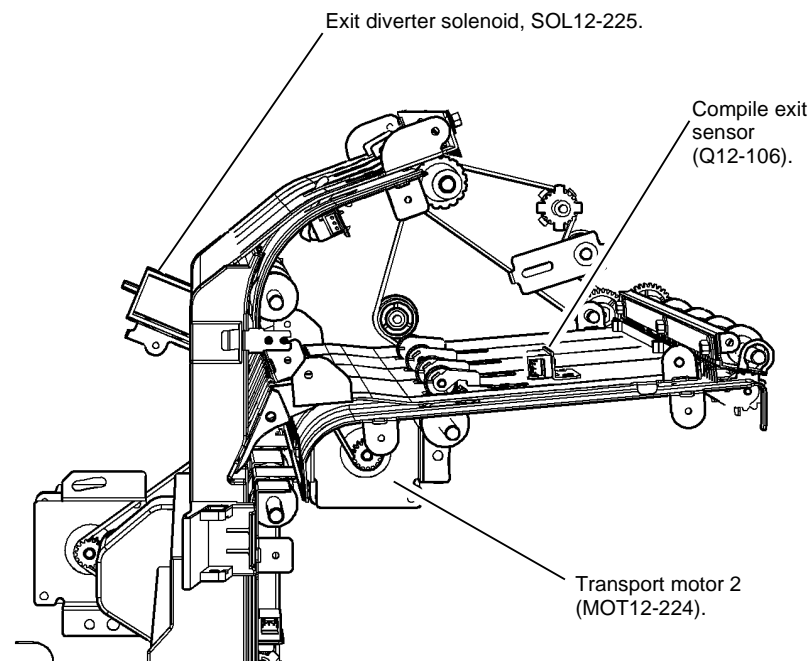
Figure 1 Component location

- Compiler exit sensor, **PL 12.135** Item 2.
- Exit diverter solenoid, **PL 12.120** Item 4.
- Diverter gate, **PL 12.125** Item 7.
- HVF PWB, **PL 12.140** Item 2.

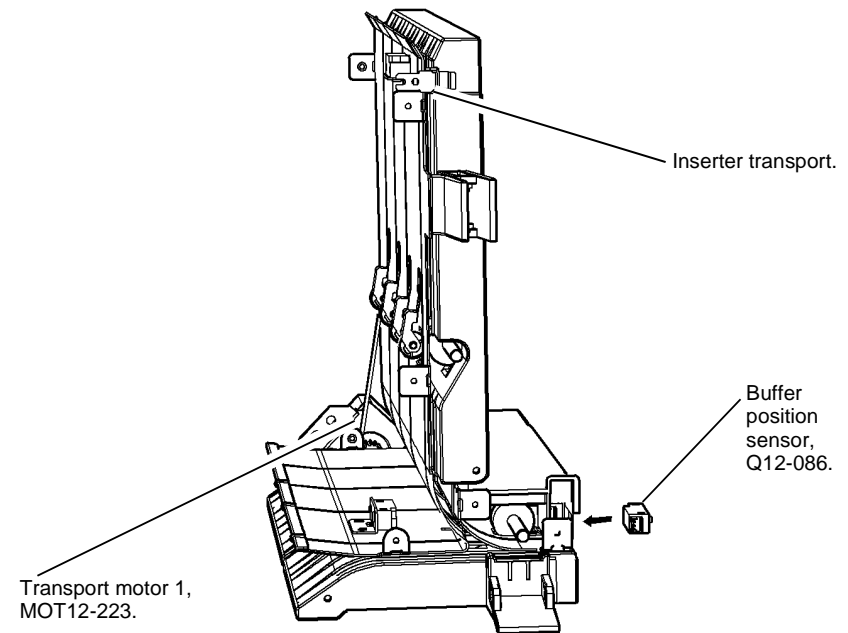
Figure 1 Component location

- Buffer position sensor, **PL 12.135** Item 2.
- Transport motor 1, **PL 12.120** Item 2.
- HVF PWB, **PL 12.140** Item 2.

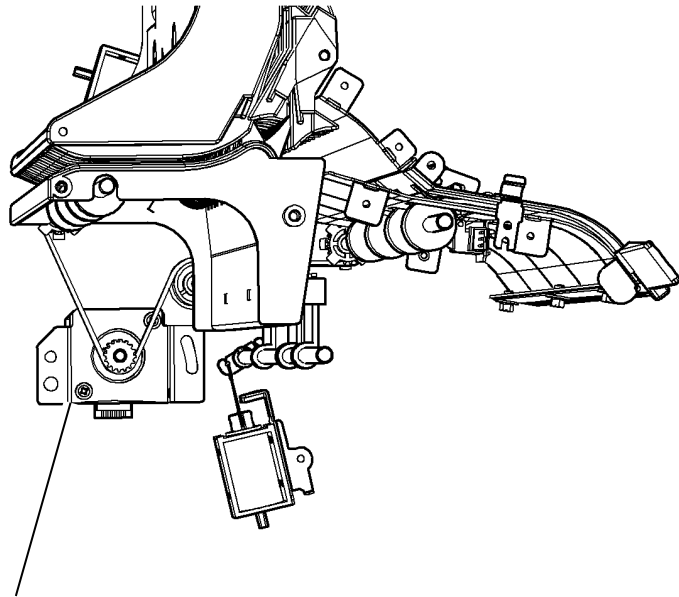
X-1-0906-A

Bypass feed motor,
MOT12-263.

Figure 2 Component location

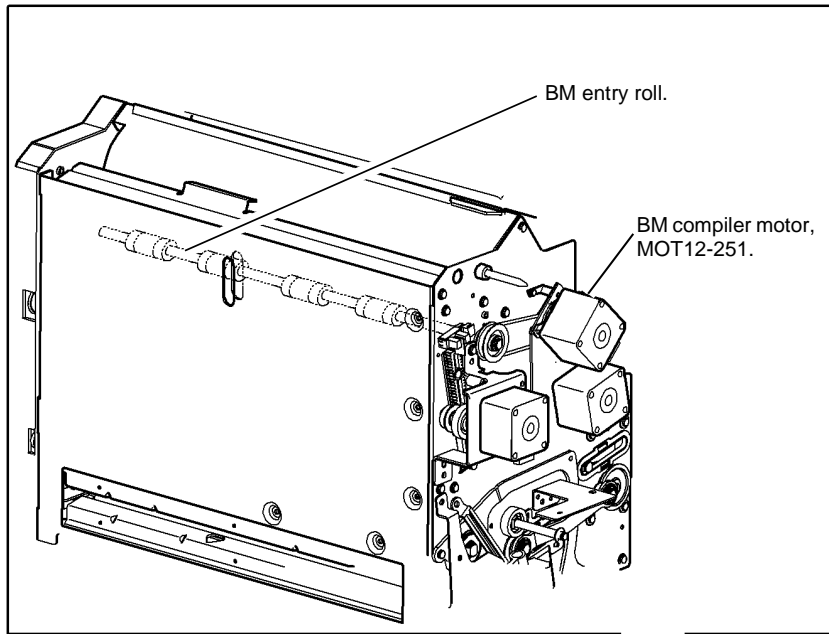
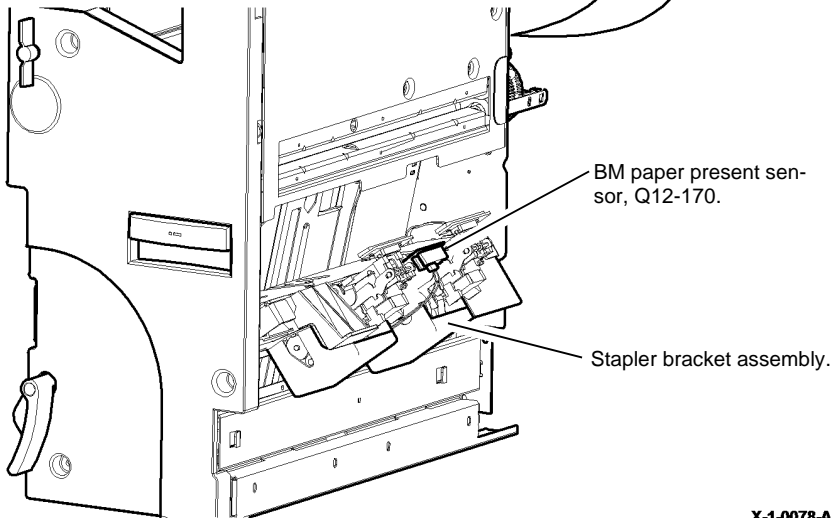
X-1-0078-A

Figure 1 Component location

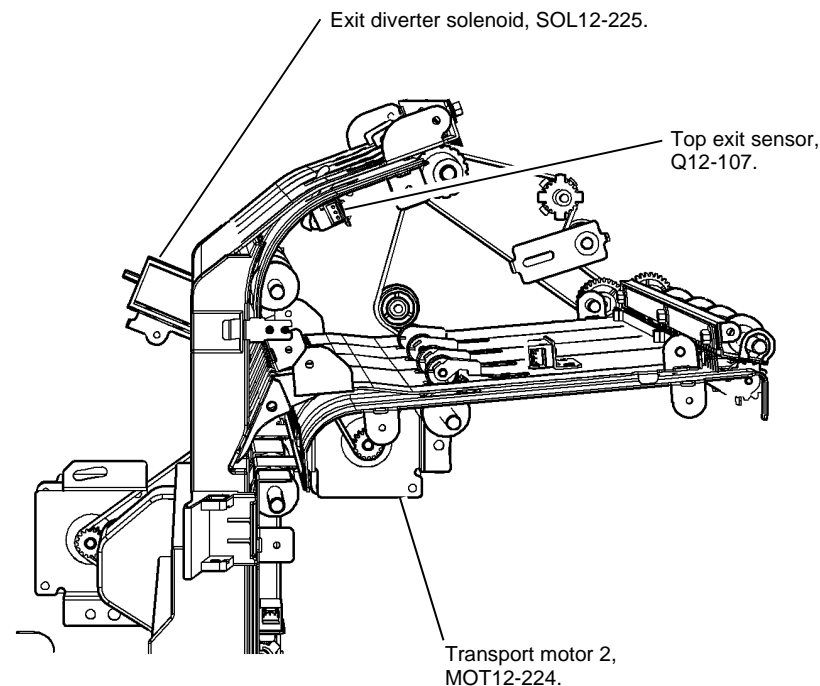
Figure 1 Component location

- Top exit sensor, [PL 12.135 Item 3](#).
- Exit diverter solenoid, [PL 12.120 Item 4](#).
- Diverter exit gate, [PL 12.125 Item 7](#).
- Transport motor 2, [PL 12.120 Item 1](#).
- HVF PWB, [PL 12.140 Item 2](#).

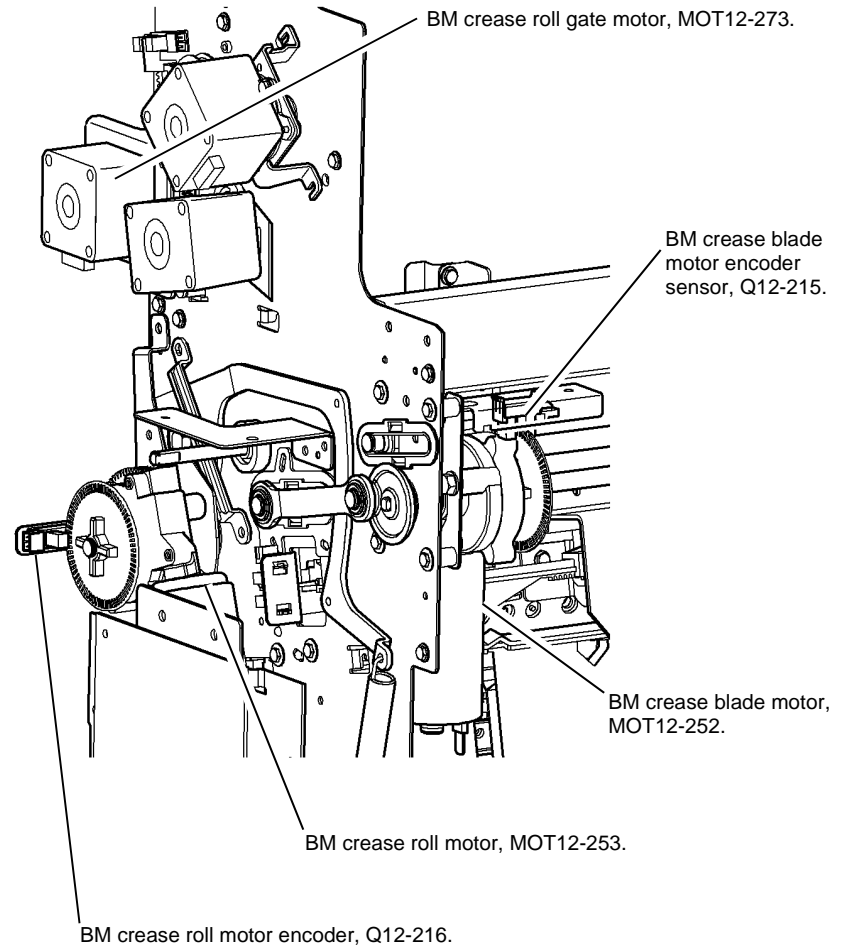
X-1-0079-A

Figure 1 Component location

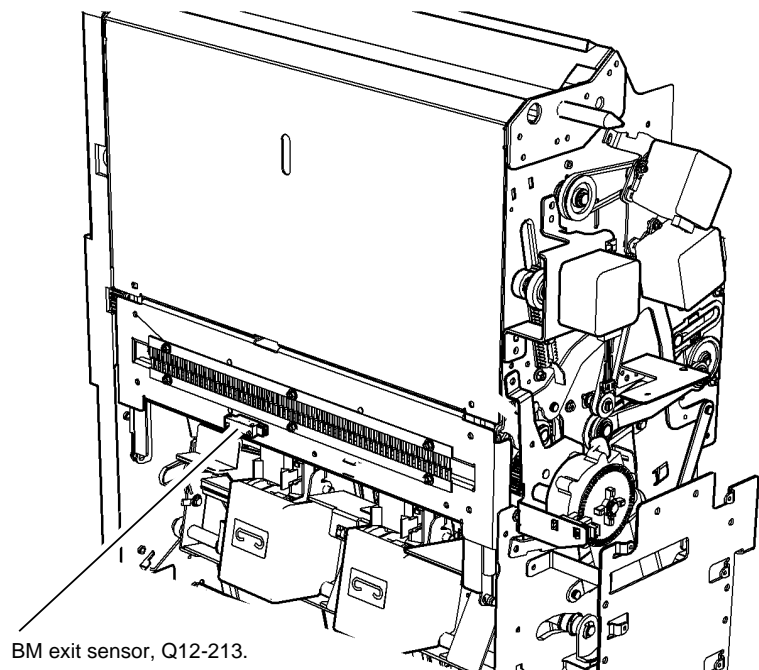
X-1-0080-A

Figure 2 Component location

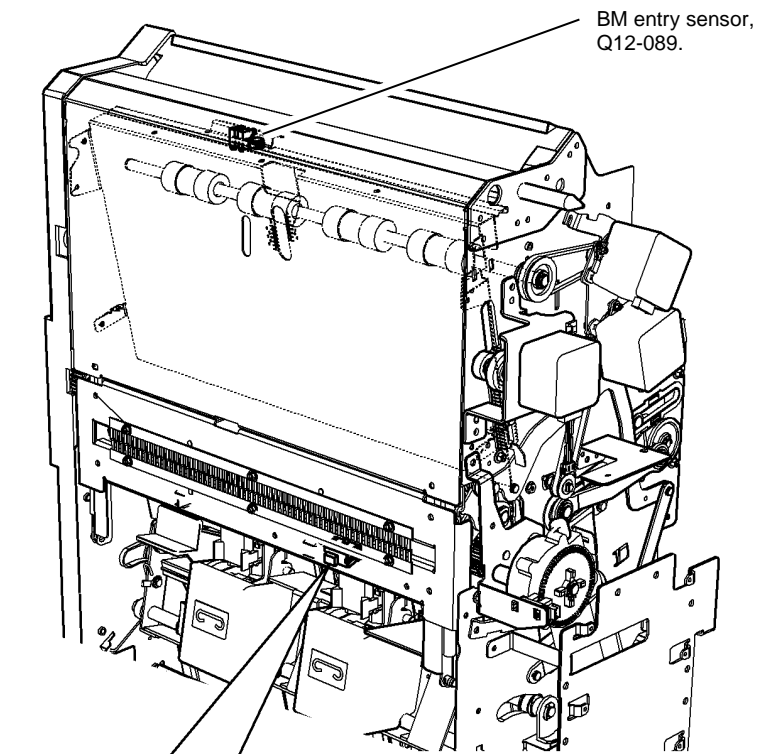
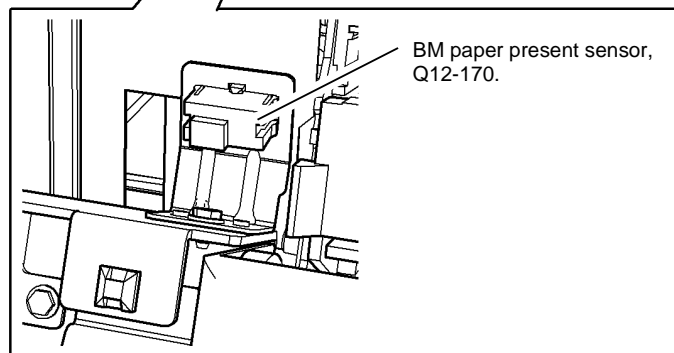
X-1-0081-A

Figure 1 Component location

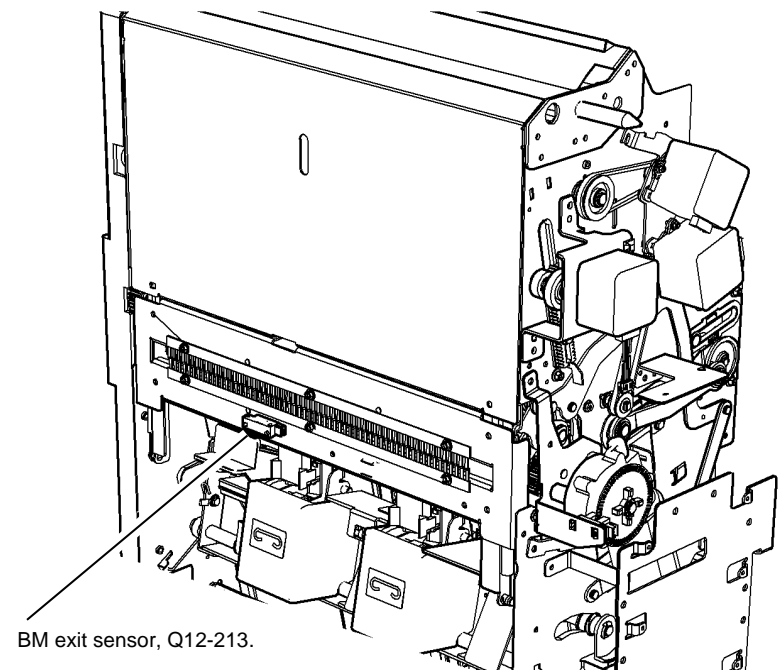
X-1-0082-A

Figure 2 Component location

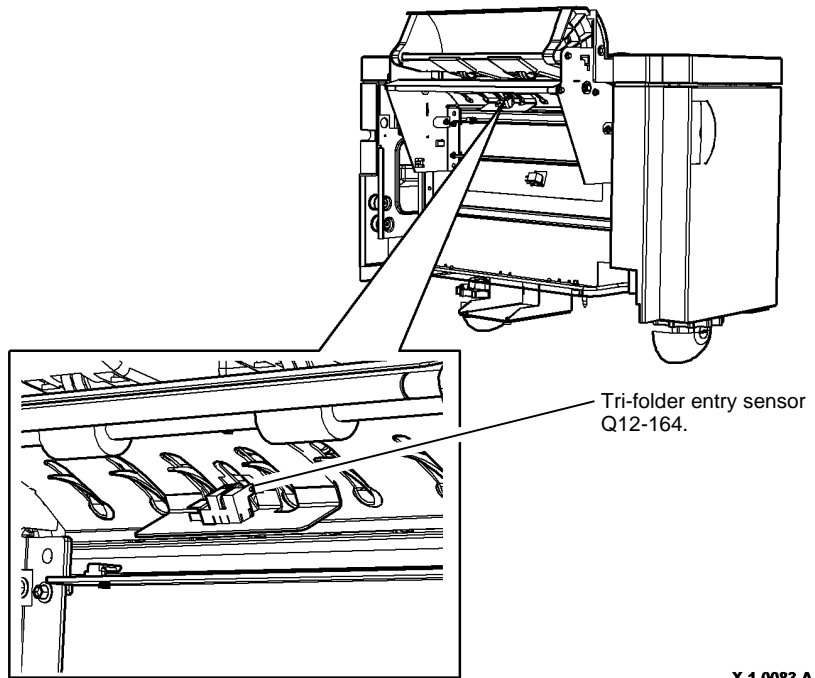
X-1-0083-A

Figure 3 Component location

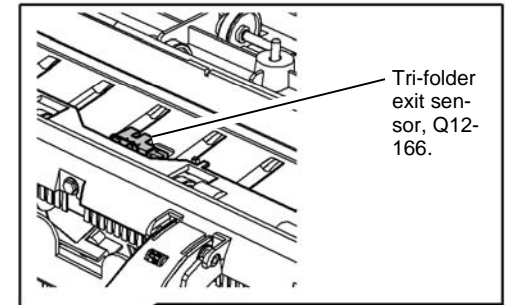
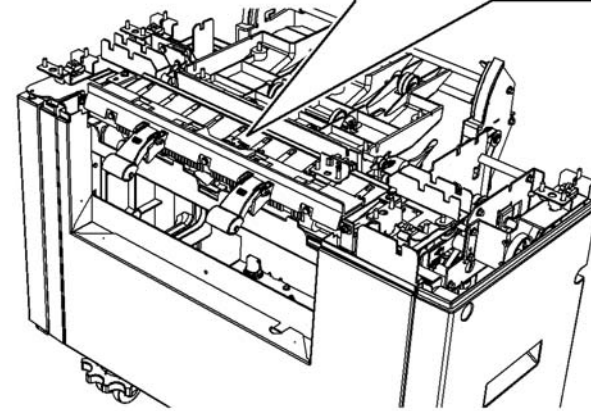
X-1-0085-A

Tri-folder exit sensor, Q12-166.

Figure 2 Component location

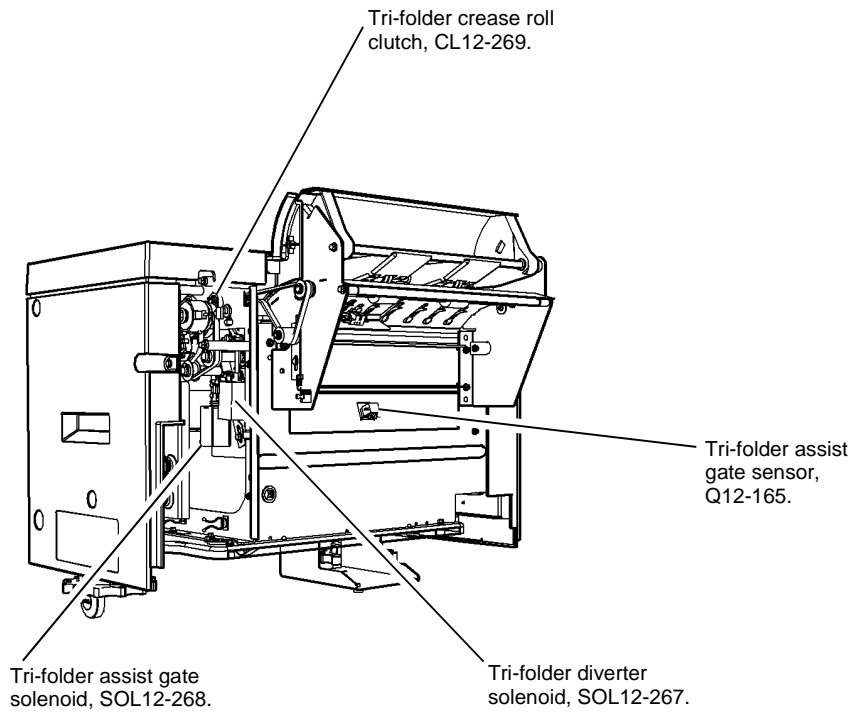
X-1-0084-A

Figure 1 Component location

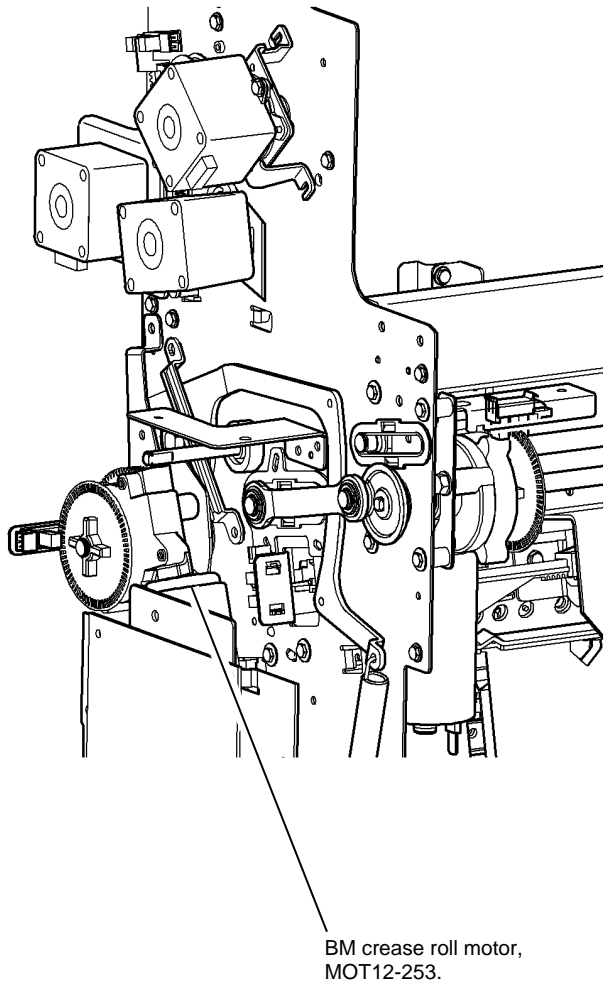
X-1-0086-A

BM crease roll motor,
MOT12-253.

Figure 3 Component location

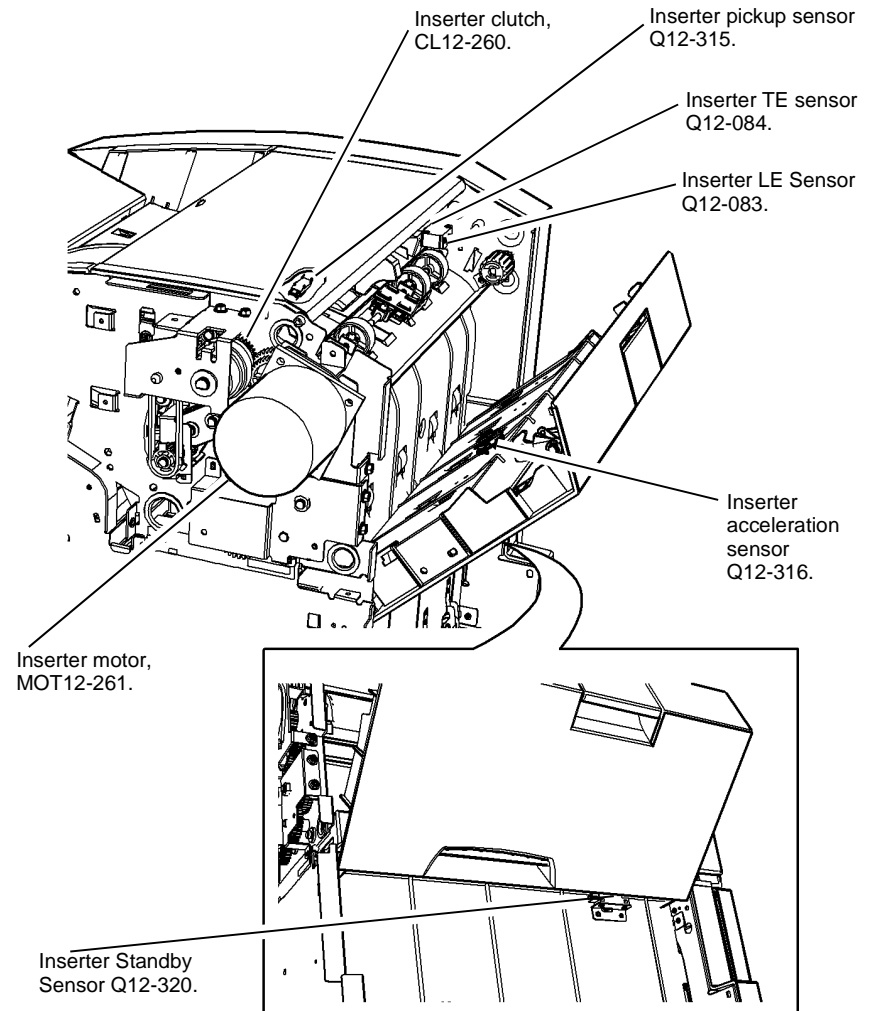
X-1-0087-A

Figure 1 Component location

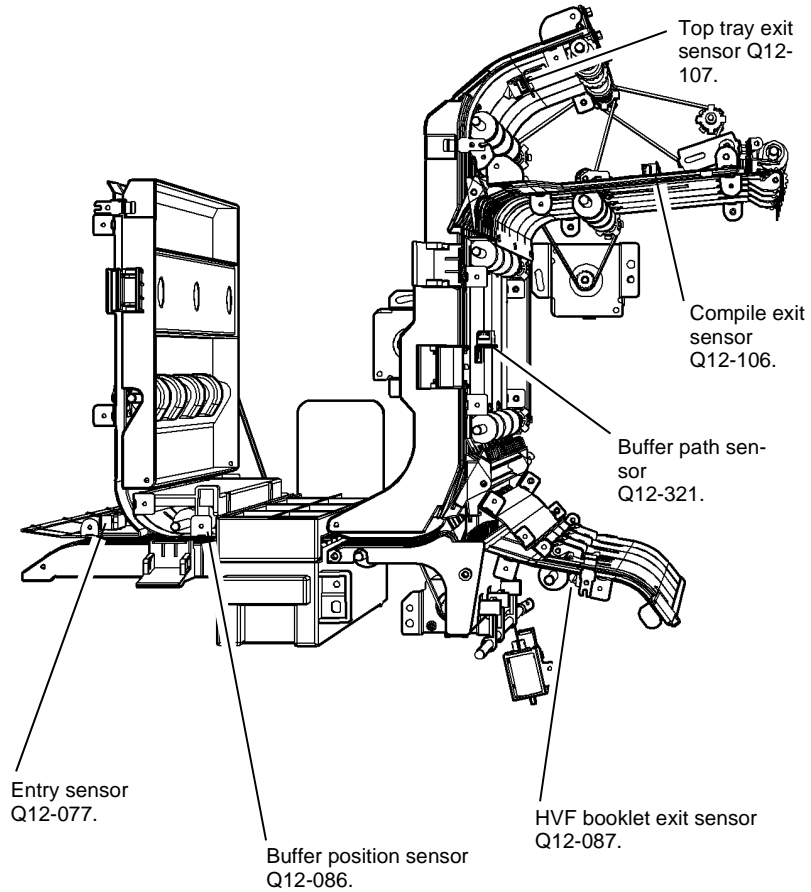
X-1-0088-A

Figure 1 Component location

- 301A 0V Distribution RAP.
- Install new components as necessary:
- HVF booklet exit sensor, PL 12.135 Item 3.
 - HVF PWB PL 12.140 Item 2.

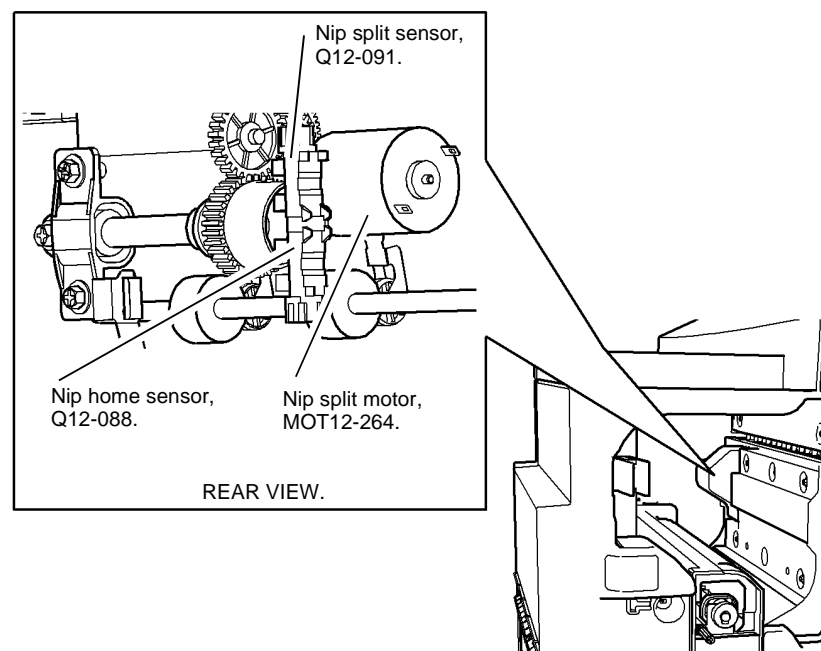
Figure 1 Component location

- Nip split sensor, [PL 12.135](#) Item 1.
- HVF PWB, [PL 12.140](#) Item 2.

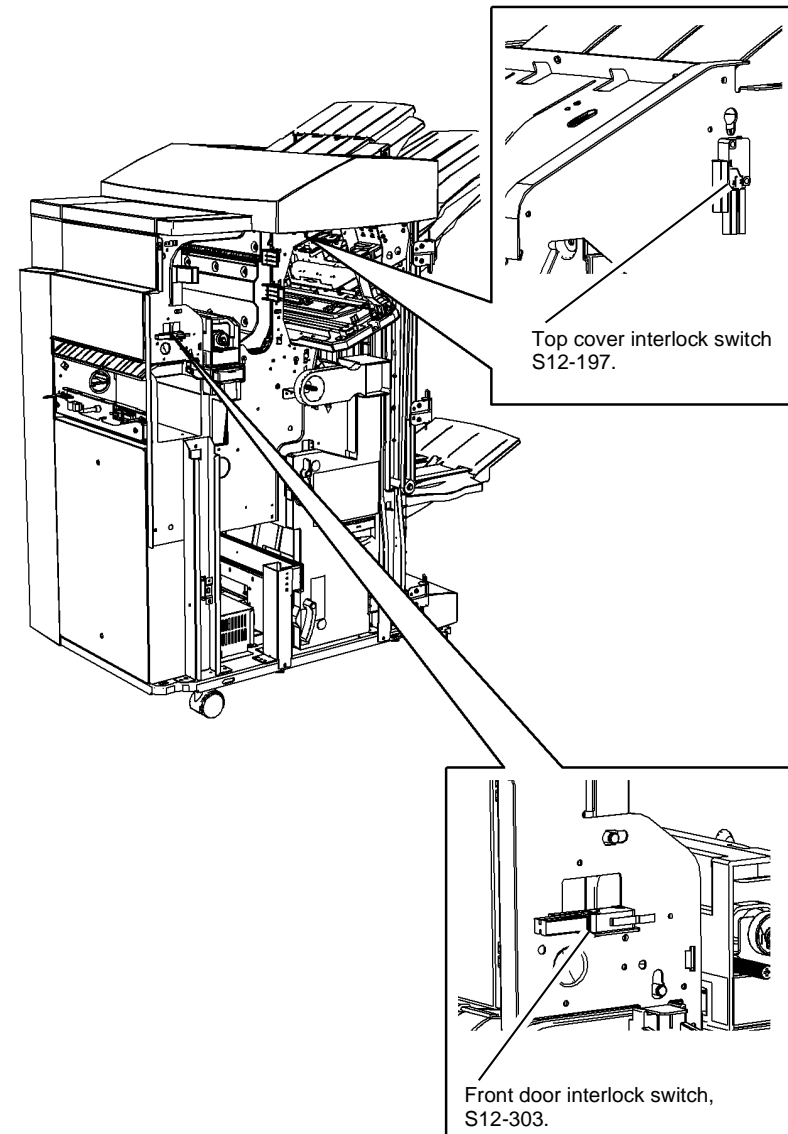
X-1-0090-A

Figure 1 Component location

- GP 13 How to Check a Switch.
- P/J112, HVF PWB.
- Check the wiring, REP 1.1.
- If necessary, install a new front door interlock switch, PL 12.115 Item 28.

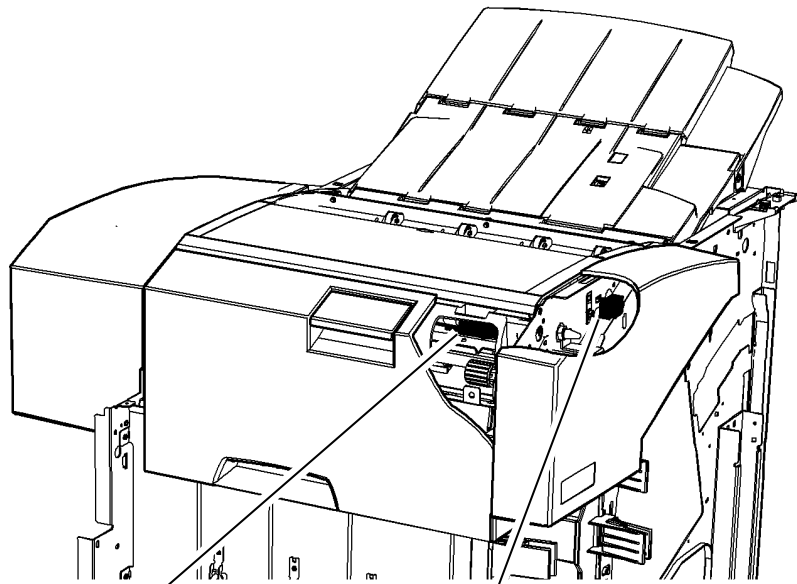
Figure 2 Circuit diagram

Inserter jam cover interlock switch, S12-179.

Inserter top cover interlock switch, S12-178.

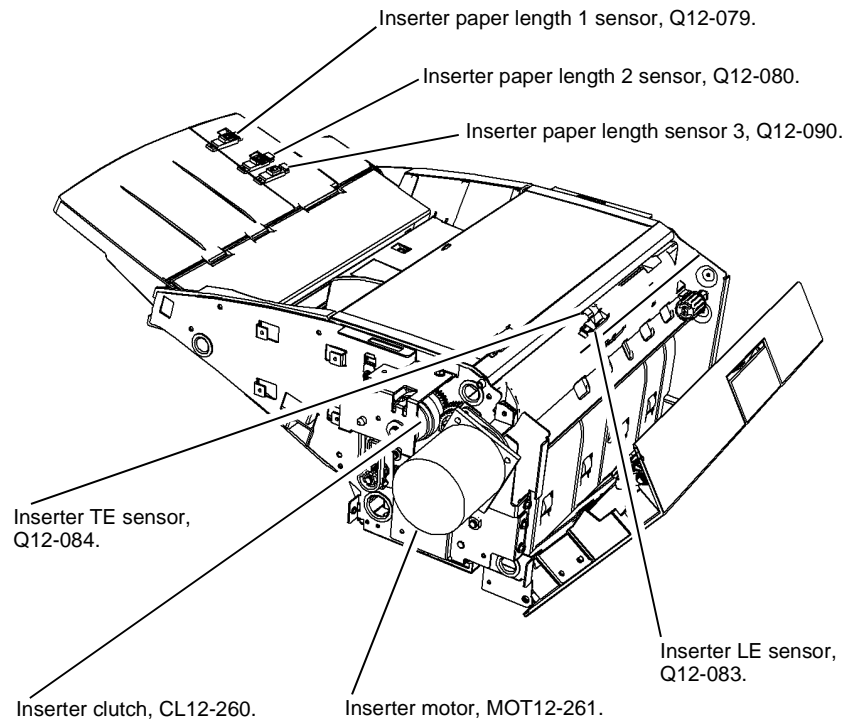
Figure 1 Component location

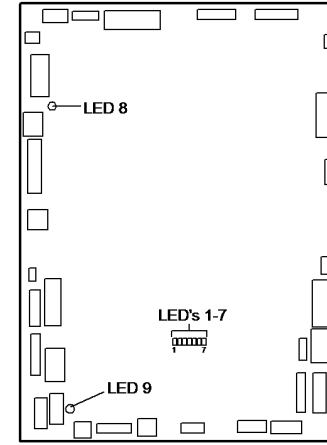
X-1-0111-A

Figure 1 LEDs on the HVF PWB

- LED 8 - red, steady. This indicates that the HVF top cover and front door interlocks are all closed and +24V is available at the HVF module.
- LED 9 - red, steady. This indicates that the +5V supply is present in the HVF module.

Figure 1 shows the LED's on the HVF PWB.

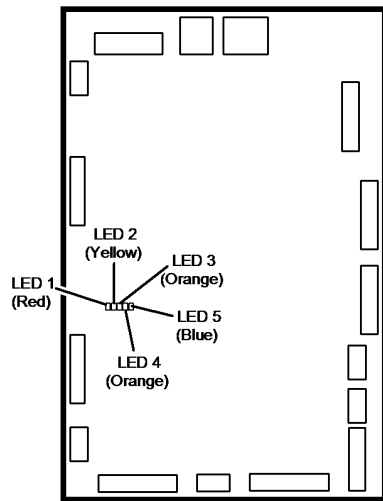
X-1-0112-A

Figure 2 LEDs on the BM PWB

The LEDs are:

- LED 1 - red, steady. This indicates a fault or other abnormal status.
- LED 2 - yellow, flashing at about 1Hz. This indicates that the software is operating in normal mode. In other modes, e.g., software downloading, the flashing rate is higher.
- LED 3 - orange, steady. This indicates either:
 - that the tri-folder front door and top cover interlocks are closed, and +24V is available to the BM module or, if the tri-folder is not installed;
 - that the interlock cheater is present in PJ553 on the BM control PWB the logic cheater is present in PL563 on the BM control PWB.
- LED 4 - orange, steady. This indicates that the +24V supply is within voltage and current limits, and that the power limiting circuit has not been active for over a set time limit.
- LED 5 - blue, steady. This indicates that the +5V supply is present in the BM module.

Figure 2 shows the LED's on the BM PWB.

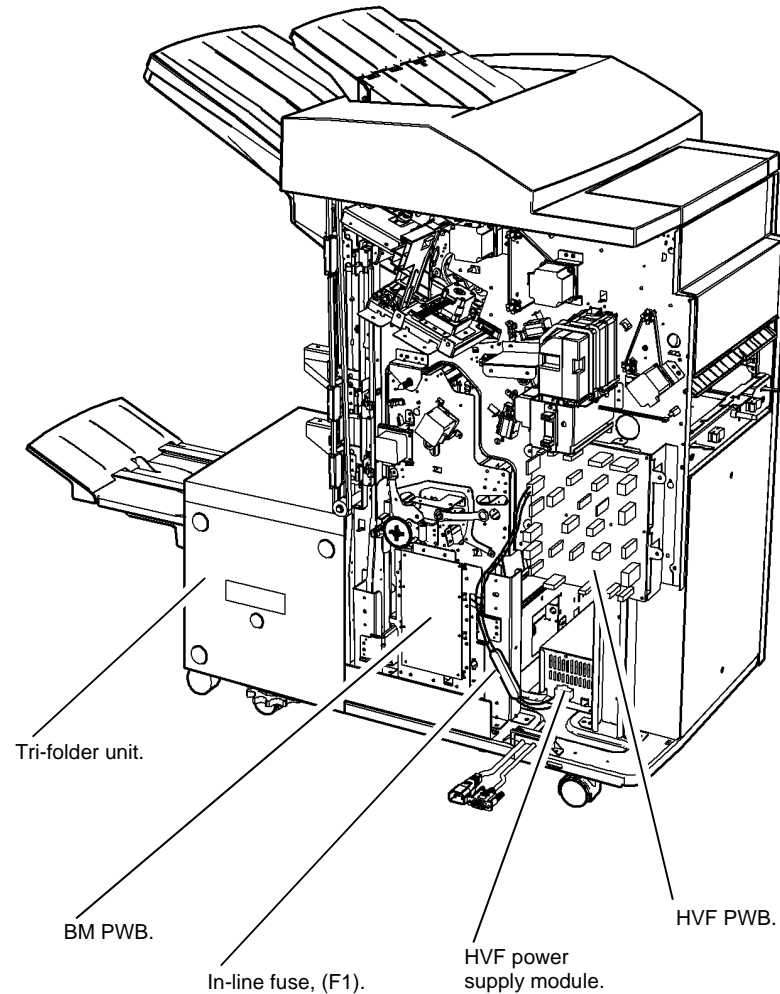
X-1-0113-A

Figure 3 Component location

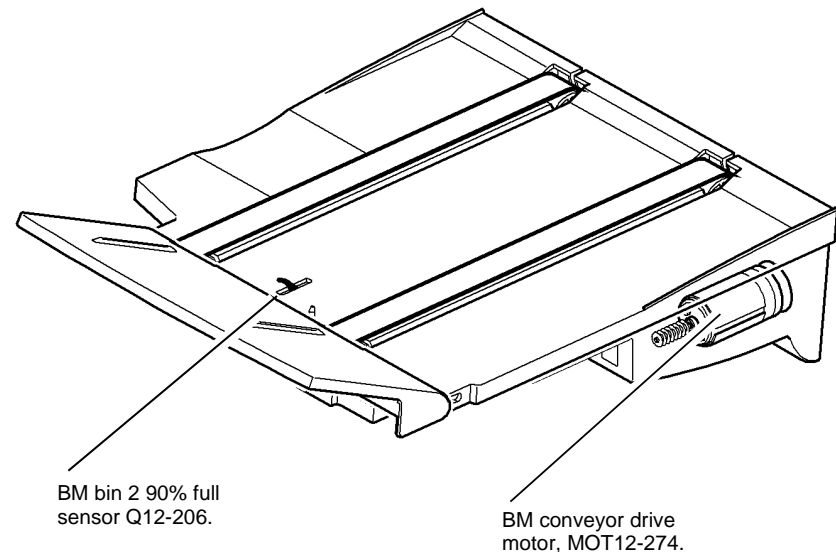
X-1-1786-A

Figure 1 Component location

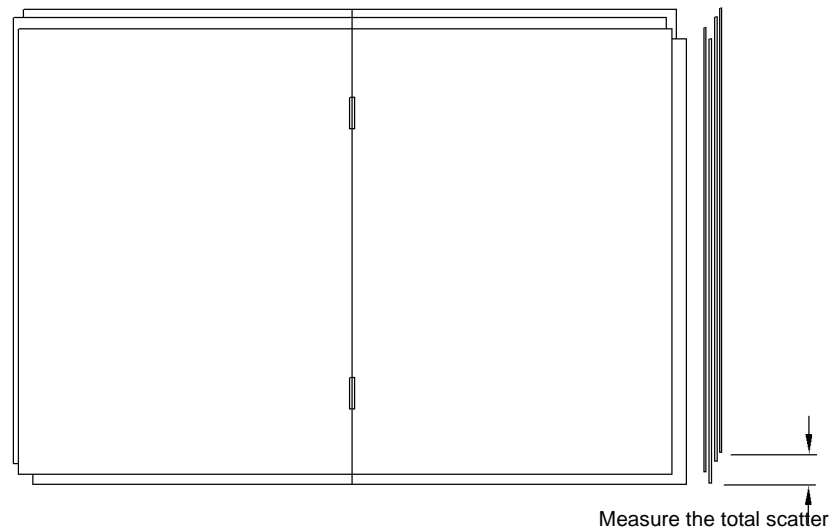
Figure 1 Top and bottom alignment

Figure 1, open out the booklet at the centre page and press it onto a flat surface. Measure the mis-alignment of the top and bottom edges of the booklet.

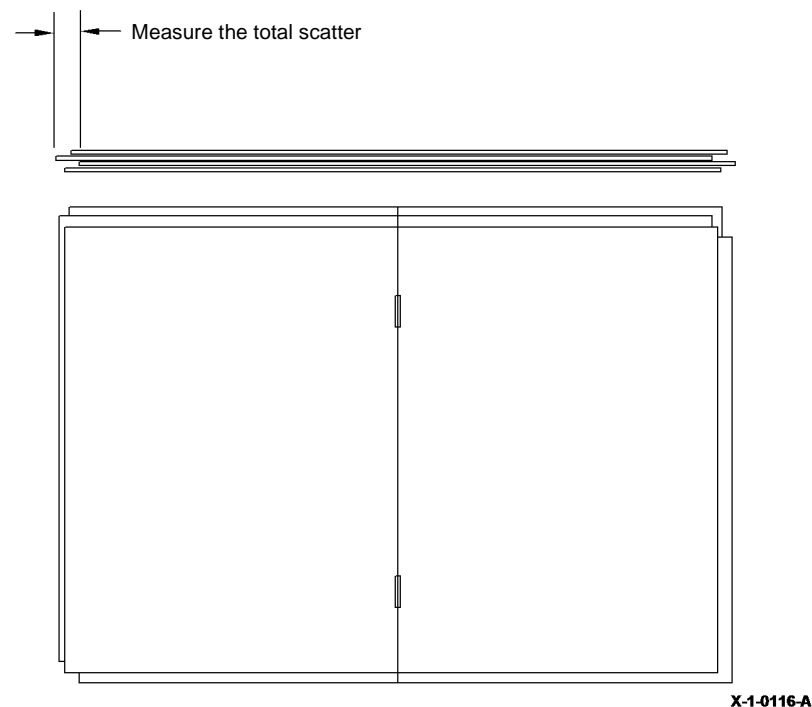
X-1-0116-A

Figure 2 Open side edge alignment

[Figure 2](#), open out the booklet at the centre page and press it onto a flat surface. Measure the mis-alignment of the open side edges of the booklet.

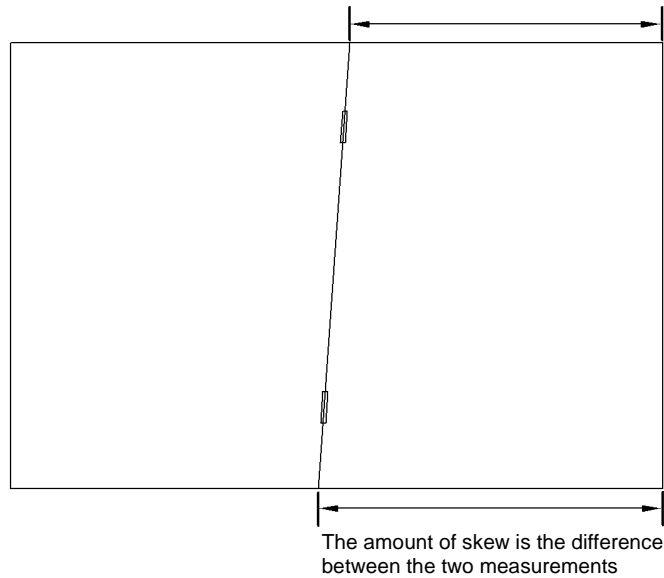
X-1-0117-A

Figure 3 Booklet skew

Figure 3, open out the booklet at the centre page and press it onto a flat surface. Measure the amount of booklet skew.

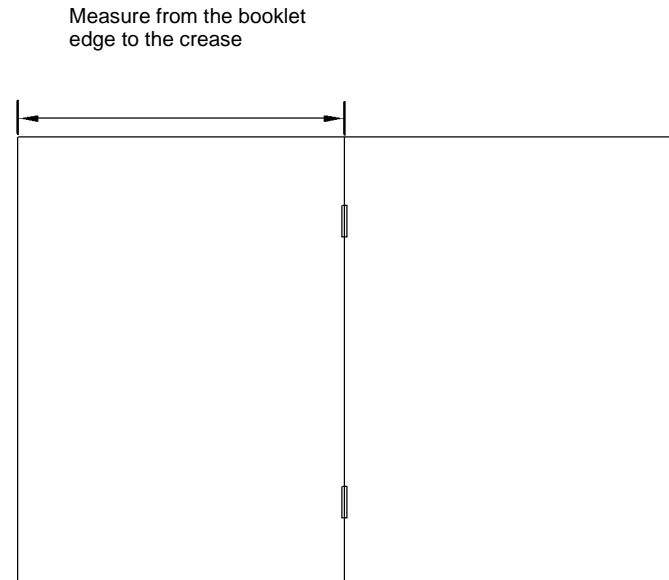
X-1-0118-A

Figure 4 Booklet crease position

Figure 4, open out the booklet at the centre page and press it onto a flat surface. Measure the position of the booklet crease.
