708P91368
September 2017

Xerox® AltaLink® B8090 Family Multifunction Printer Service Manual

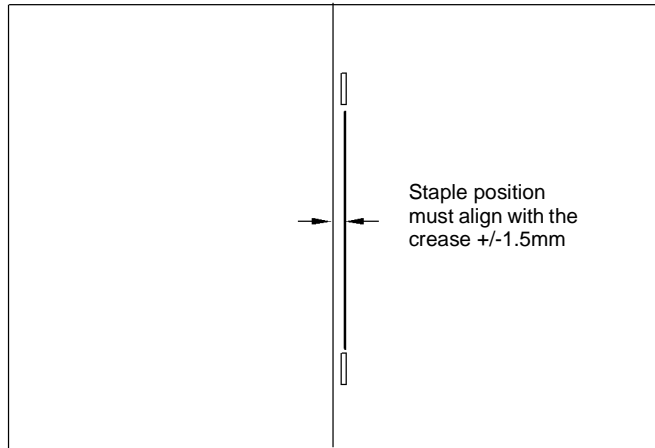
X-1-0119-A

Figure 5 Booklet staple position

[Figure 5](#), open out the booklet at the centre page and press it onto a flat surface. Measure the position of the booklet staple from the crease line.

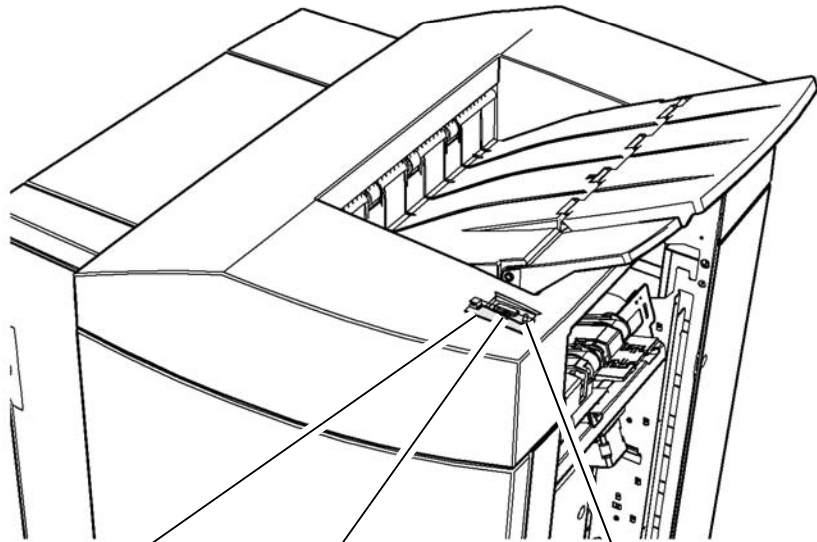
X-1-0121-A

PTU PWB.

PTU switch, S12-208.

Figure 1 Component location

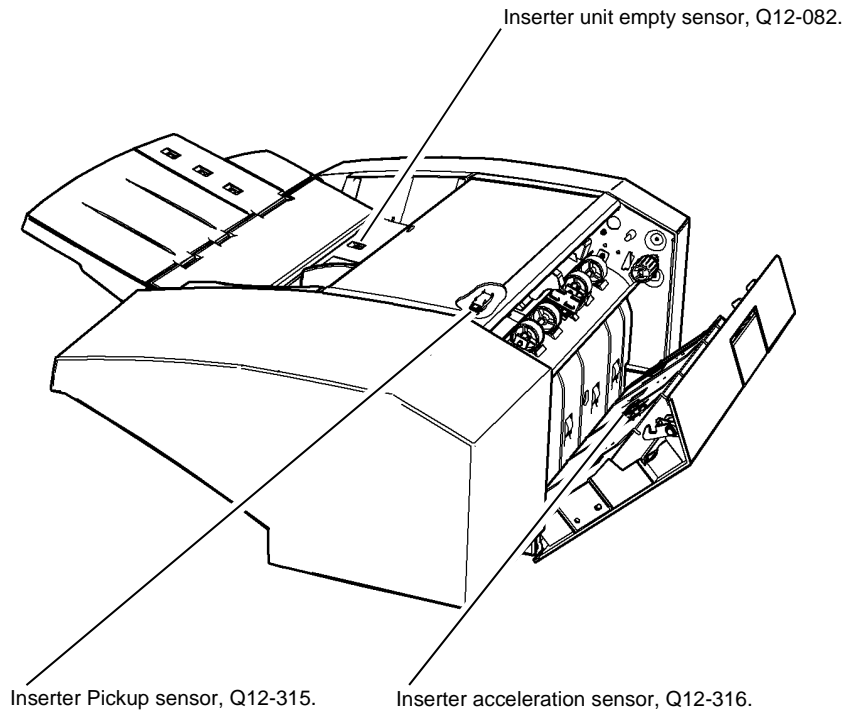
X-1-0122-A

Figure 1 Component location

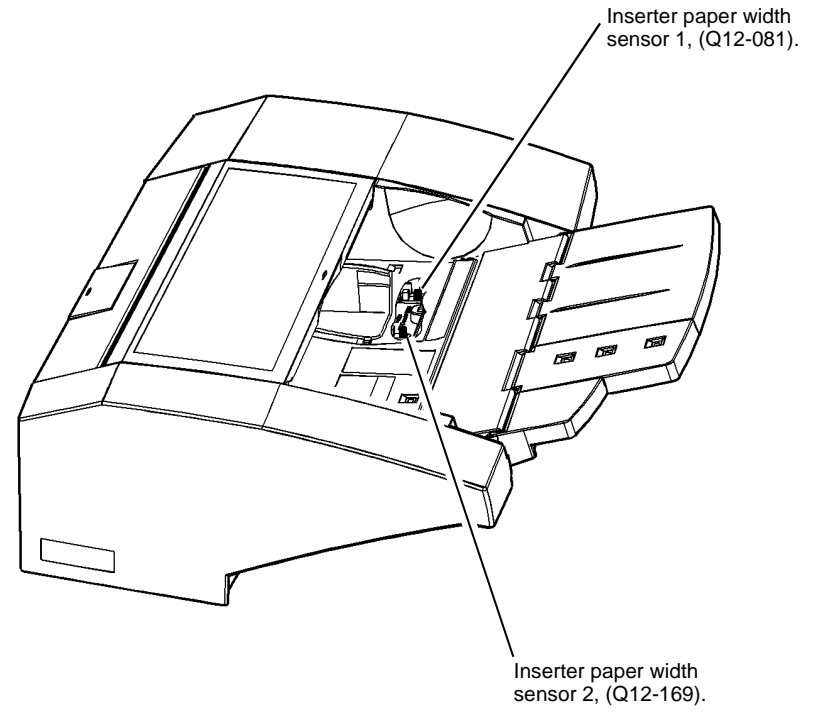
X-1-0123-A

Figure 2 Component location

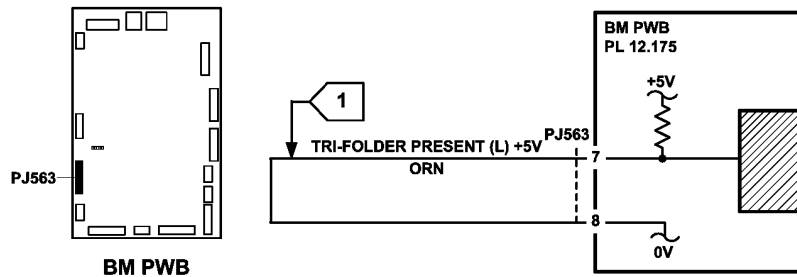
TX-1-0151-A

Figure 1 Circuit diagram

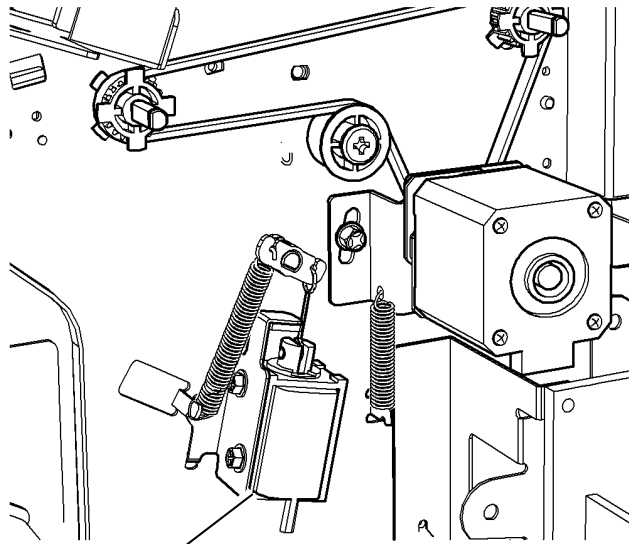
X-1-0124-A

Set clamp solenoid, SOL12-056. REAR VIEW.

Figure 1 Component location

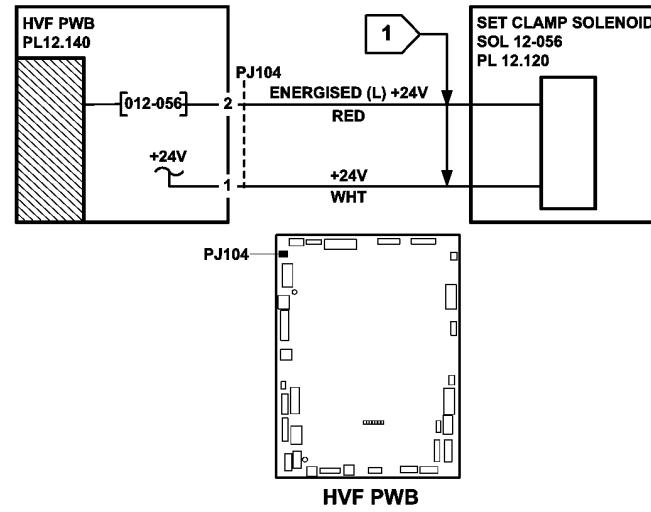
TX-1-0155-A

HVF PWB
Figure 2 Circuit diagram

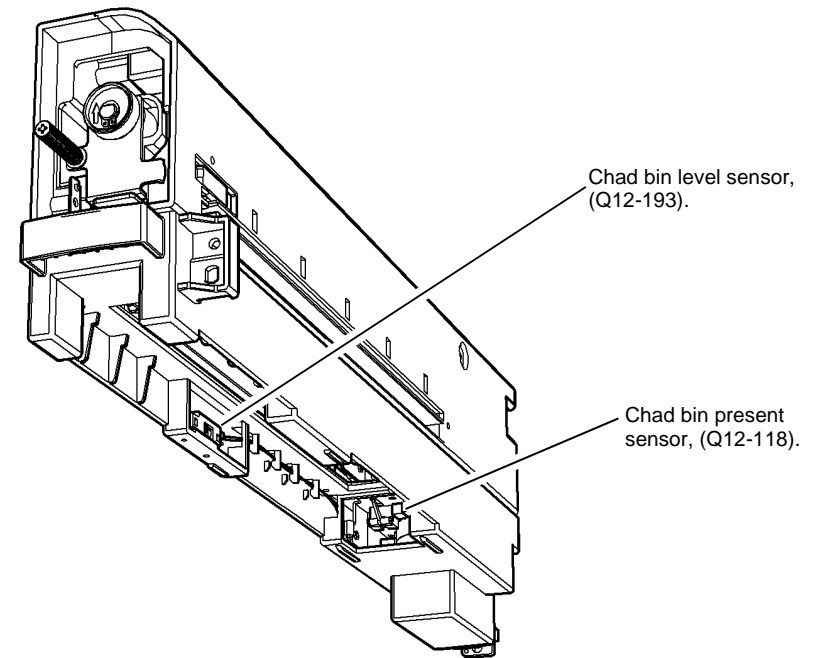
X-1-0125-A

UNDERSIDE VIEW

Figure 1 Component location

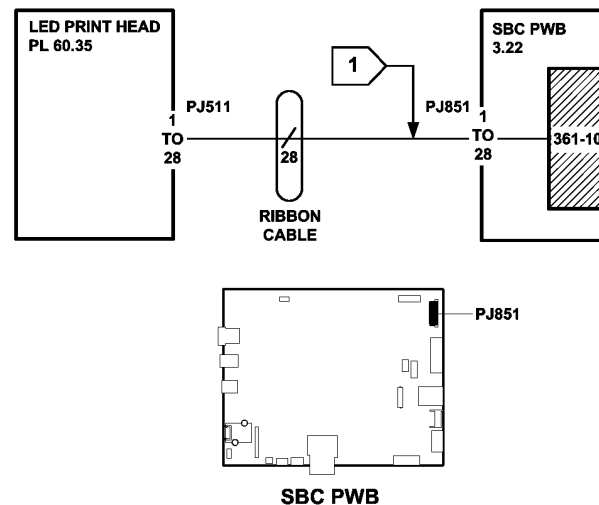
TX-1-0363-A

Figure 2 Circuit diagram

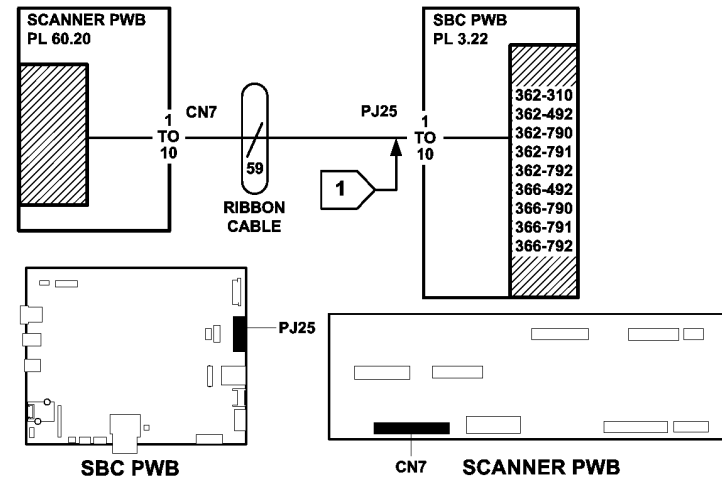
TX-1-0364-A

Figure 2 Circuit diagram

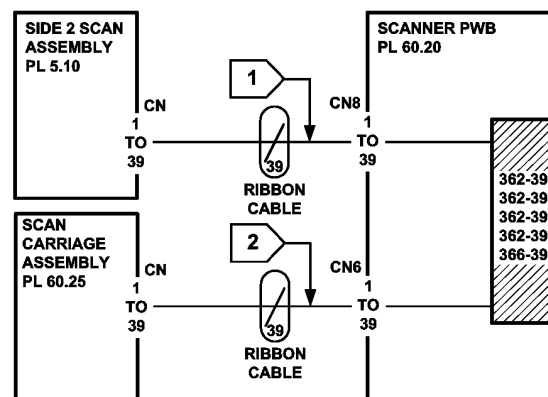
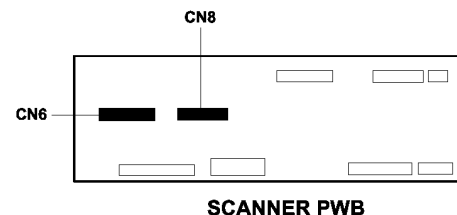
TX-1-0365-A

Figure 2 Circuit diagram

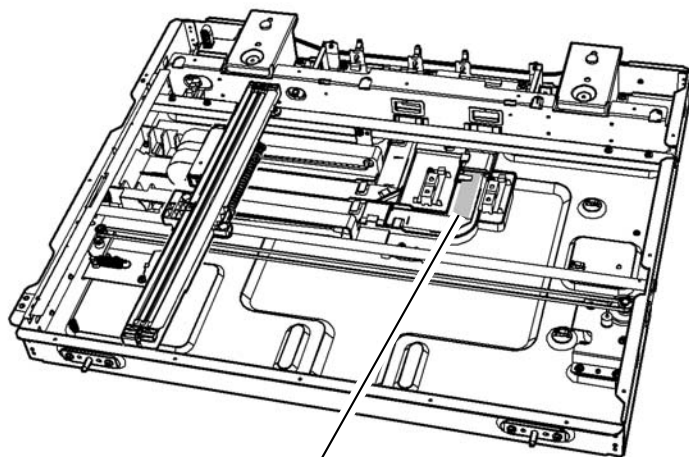
X-1-1915-A

Scan carriage data ribbon cable.

Figure 2 Component location

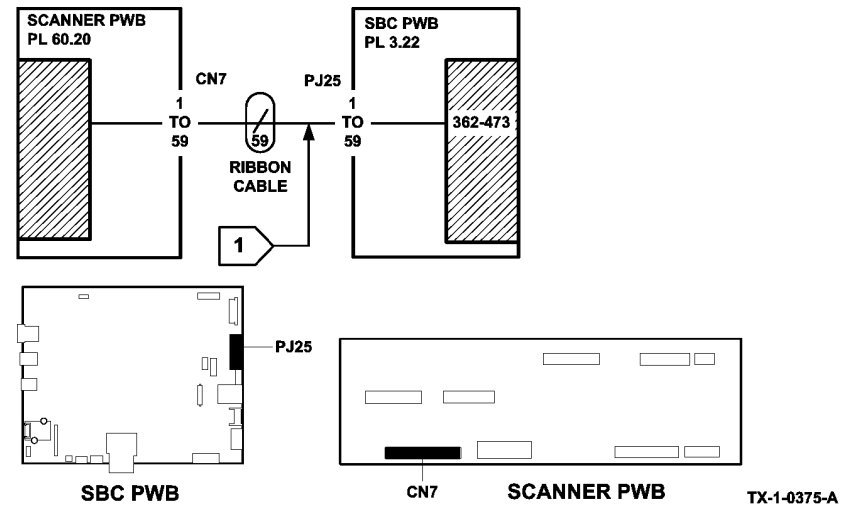
Figure 2 Circuit diagram

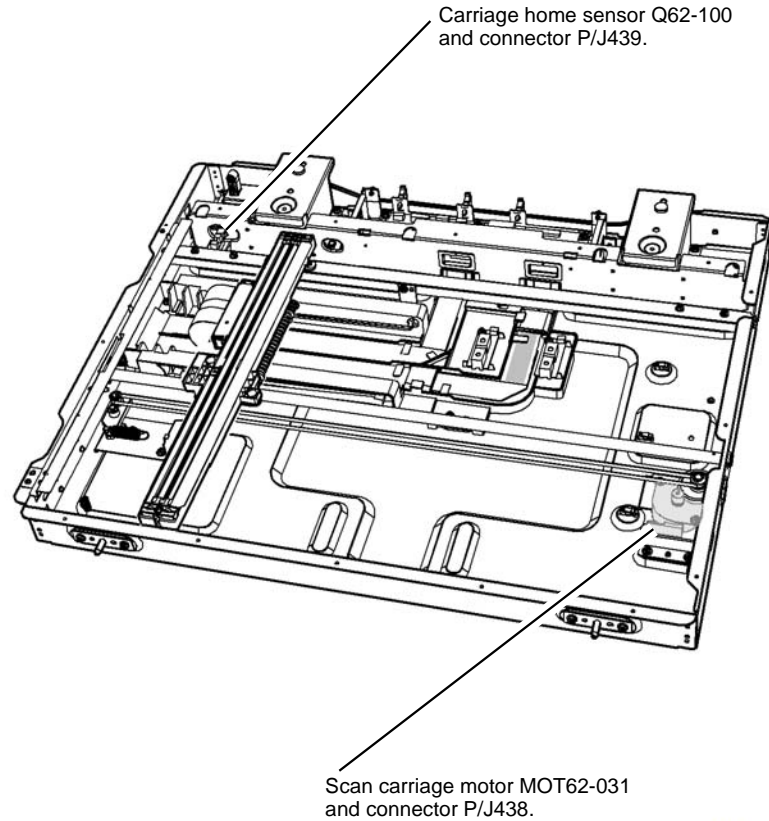
X-1-1917-A

Figure 1 Component location

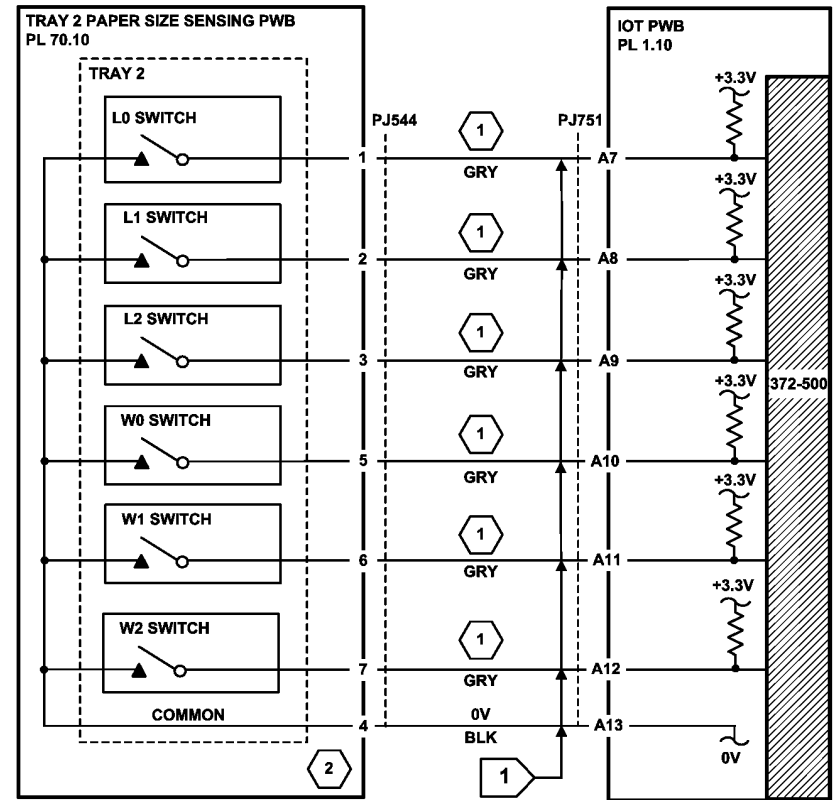
- 1 SWITCH OPEN +3.3V. CHECK THE VOLTAGE AT THE PJ ON THE PWB. TRAY CLOSED DETECTED IF ONE OR MORE SWITCHES ARE CLOSED.
- 2 LOGICAL REPRESENTATION OF SIZE SENSING SWITCHING. CIRCUITS ARE COMPLETED BY CONTACT SPRINGS ON REAR OF TRAY 2.

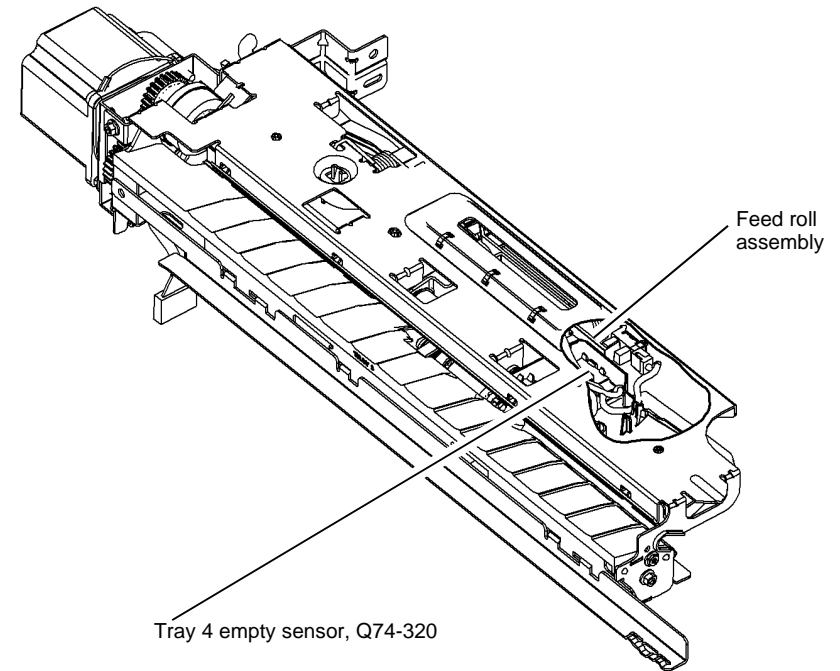
X-1-0984-A

Figure 1 Component location

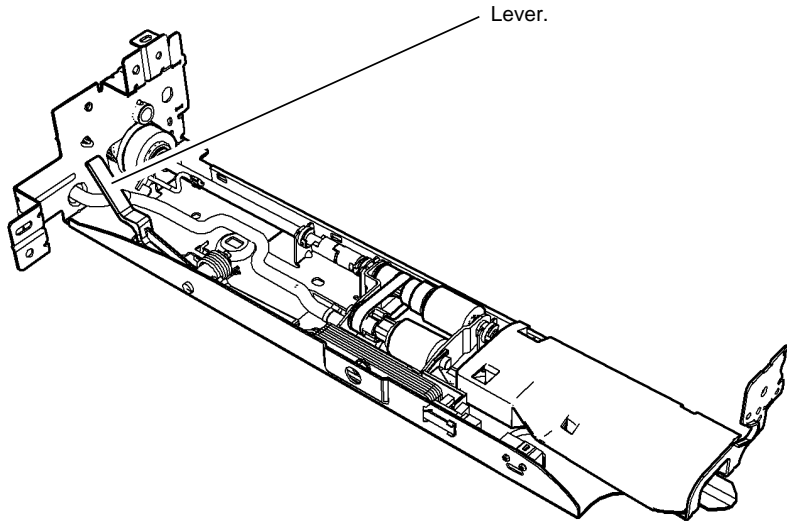
X-1-1300-A

Figure 2 Component location

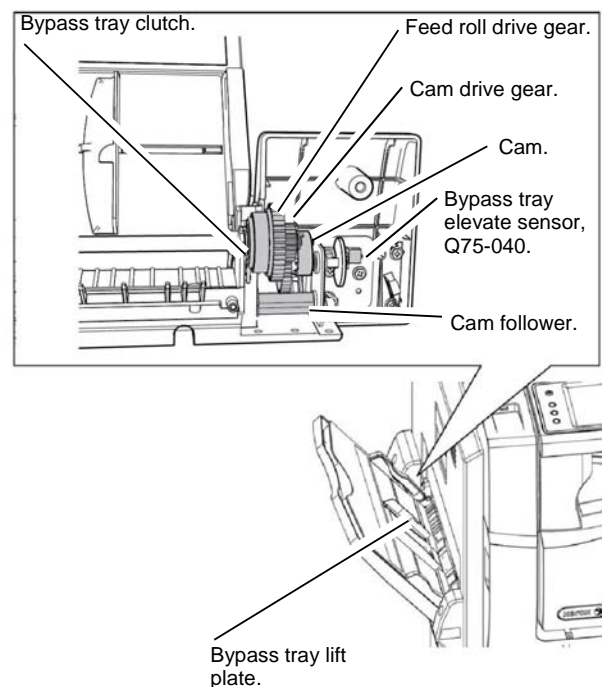
X-1-1249-A

Figure 1 Component location

- Check the condition of the media used in the bypass tray. Refer to [IQ1](#) and [GP 20](#).
- Ensure that the width guides are touching the edge of the paper, [Figure 1](#).

- If there is a paper width sensing problem, check that the bypass tray width sensor, Q75-601, is not damaged, [Figure 1](#).
- Clean the bypass tray with a microfiber wiper, [PL 26.10 Item 13](#) and antistatic fluid, [PL 26.10 Item 19](#).
- Check the fault history file. If 375-100-00 codes are present, perform the [375-100-00 Bypass Tray Lift Failure RAP](#).

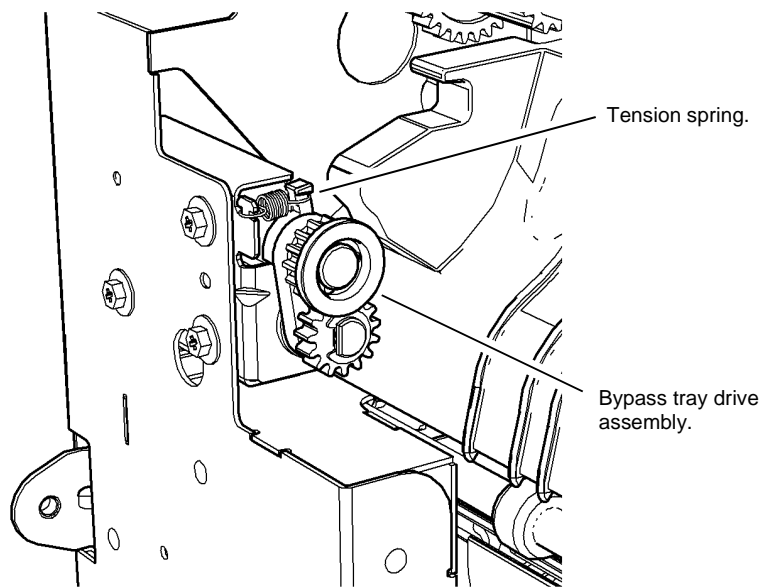
X-1-1250-A

Figure 2 Component location

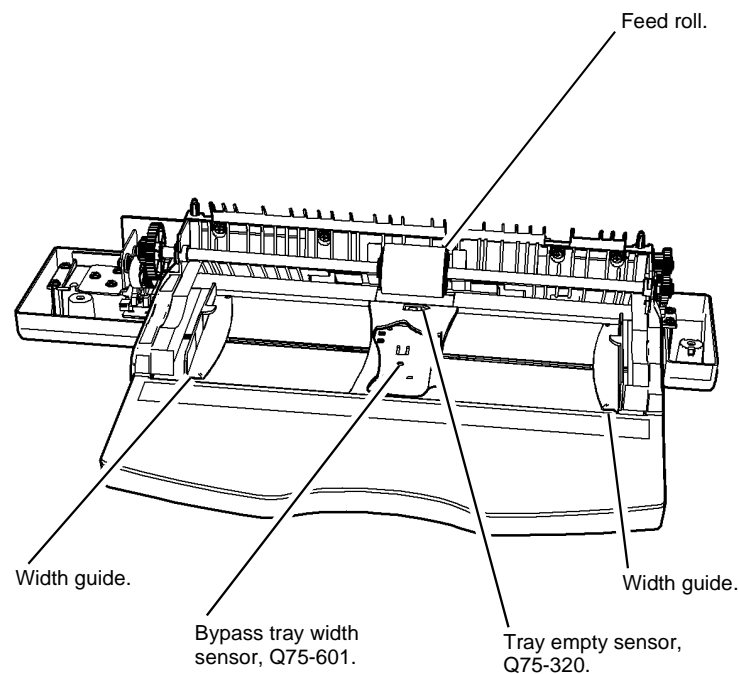
Figure 1 Component location

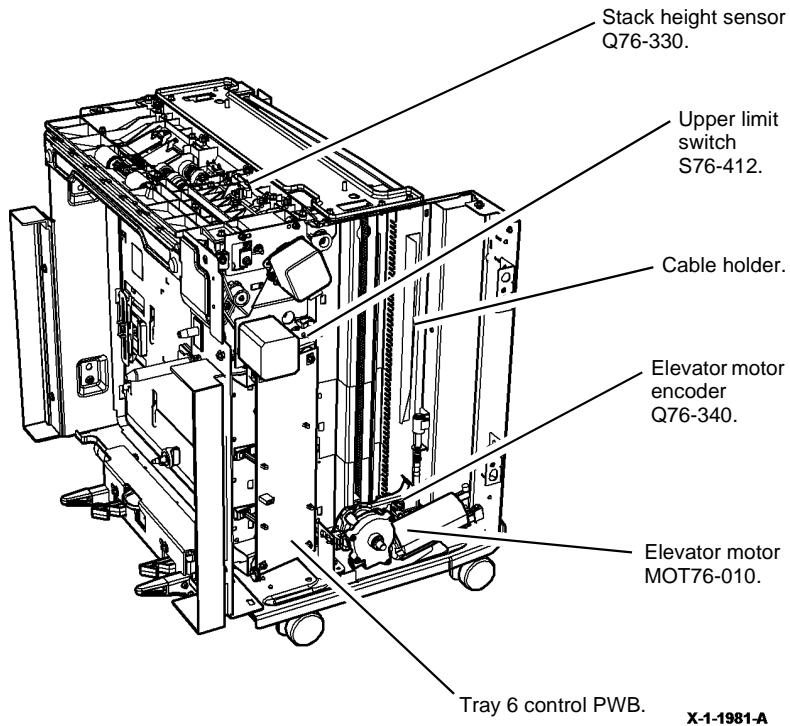
Figure 1 Component location

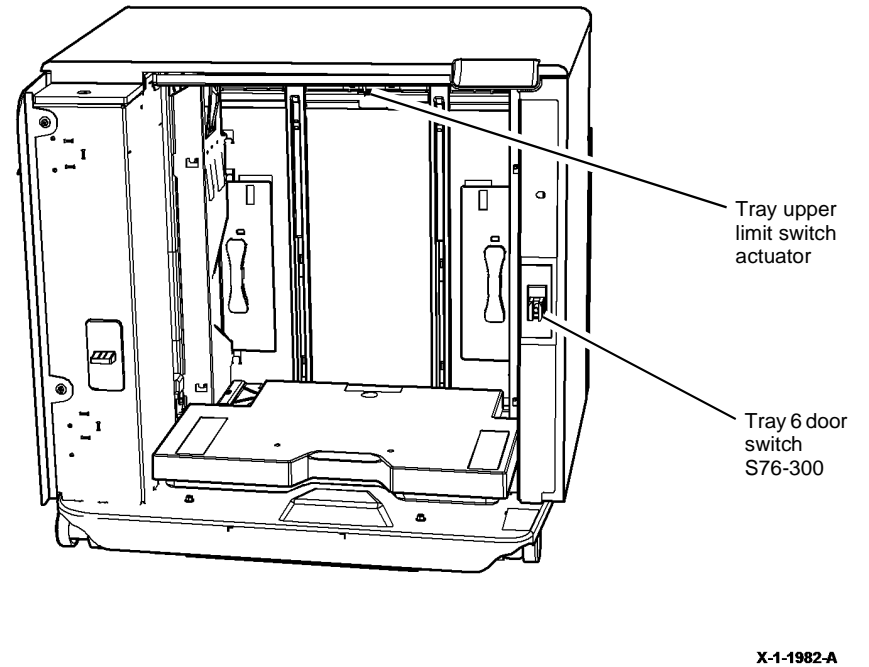
Figure 2 Component location

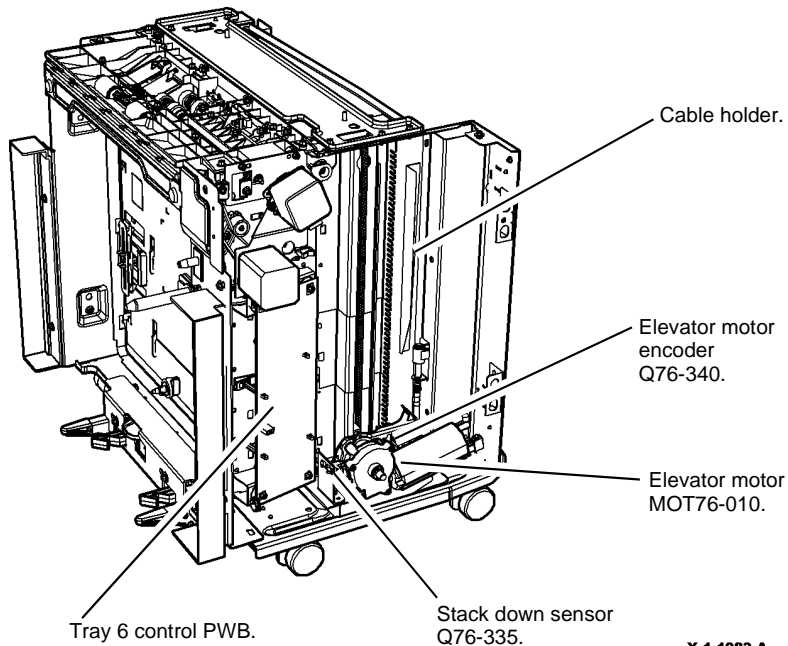
X-1-1983-A

Figure 1 Component location

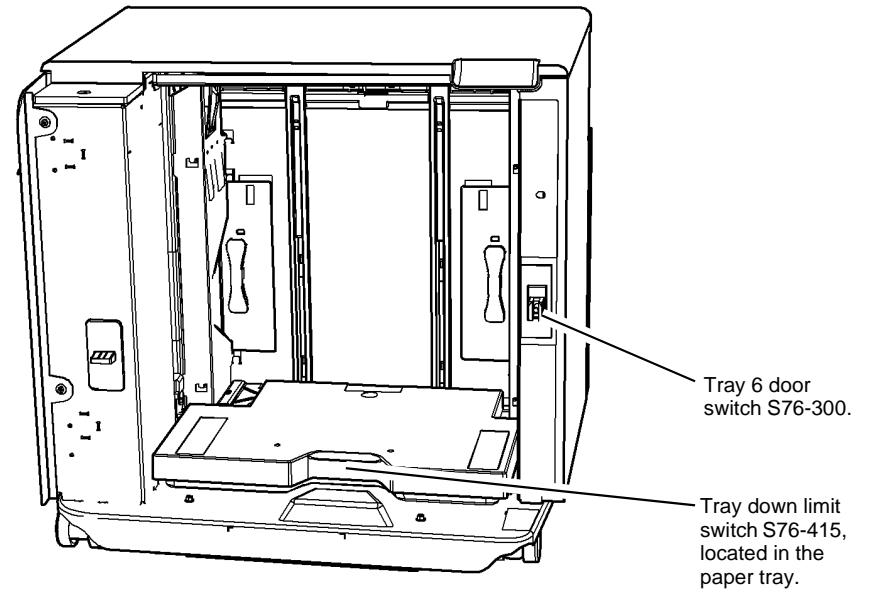
X-1-1984-A

Figure 2 Component location

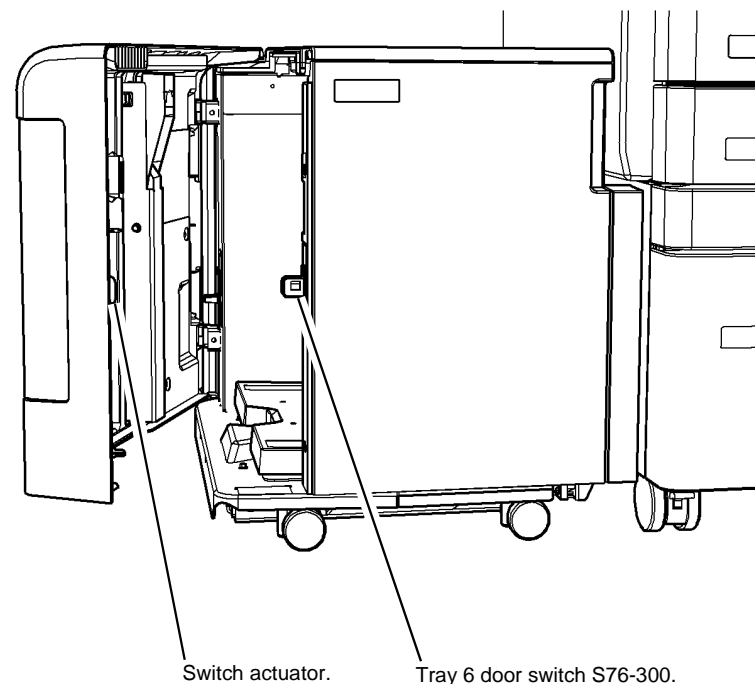
X-1-1-985-A

Figure 1 Component location

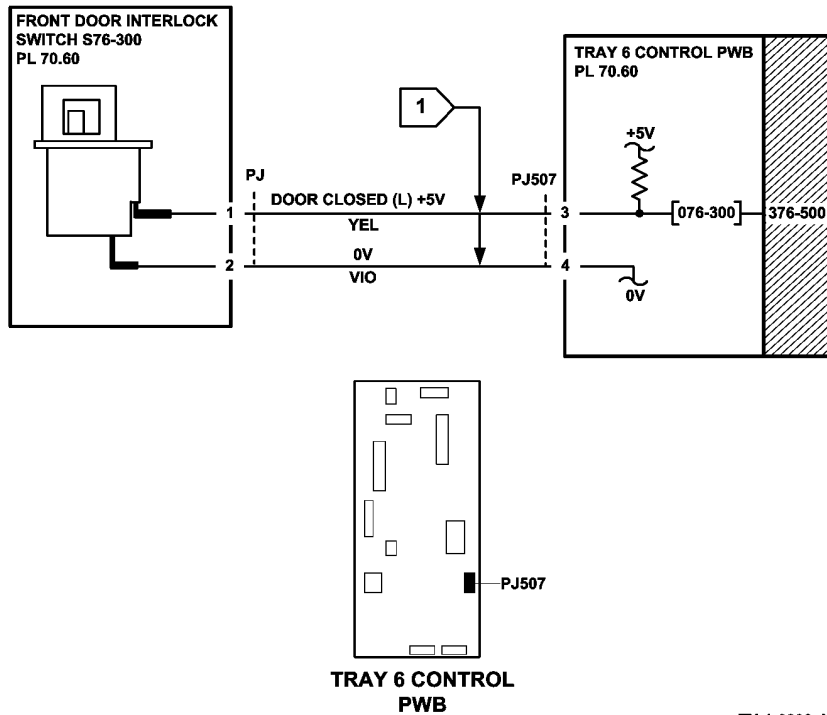
TX-1-0393-A

Figure 2 Circuit diagram

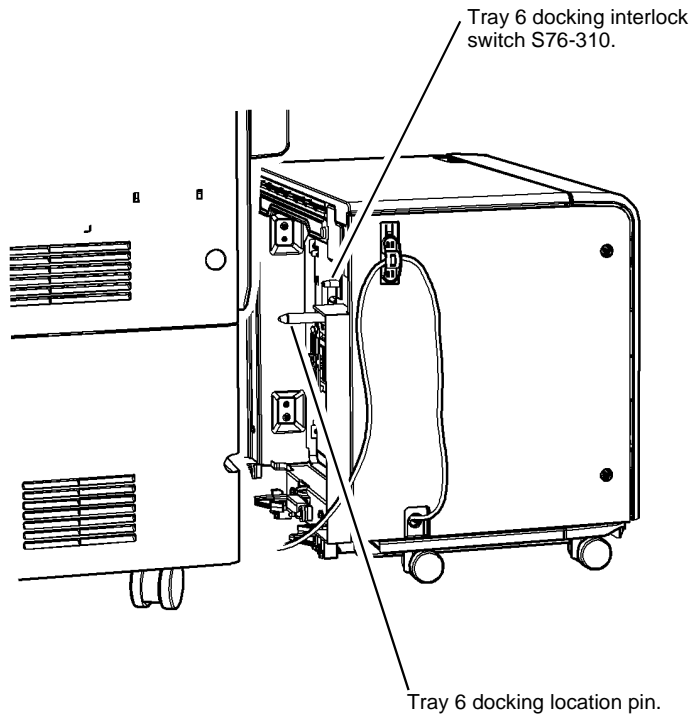
X-1-1986-A

Figure 1 Component location

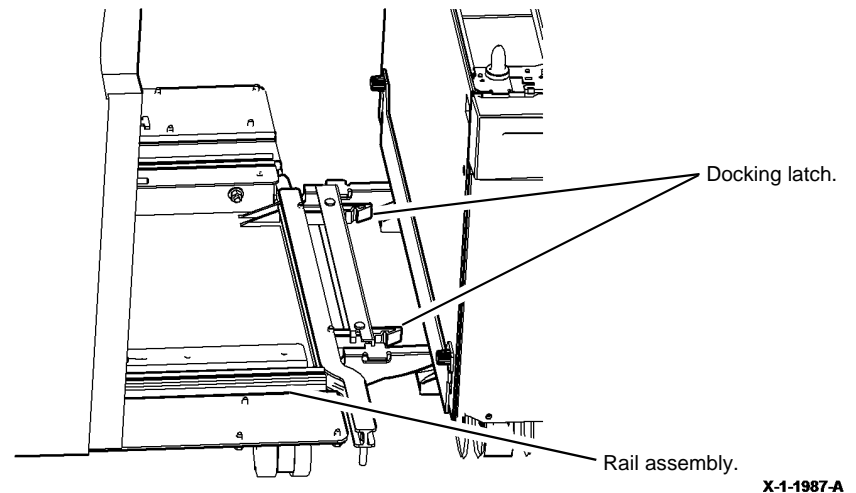
X-1-1987-A

Figure 2 Component location

- Check that the docking latch on tray 6 is latched onto the machine, [Figure 2](#).
- Check that the rail assembly is located correctly to the machine.

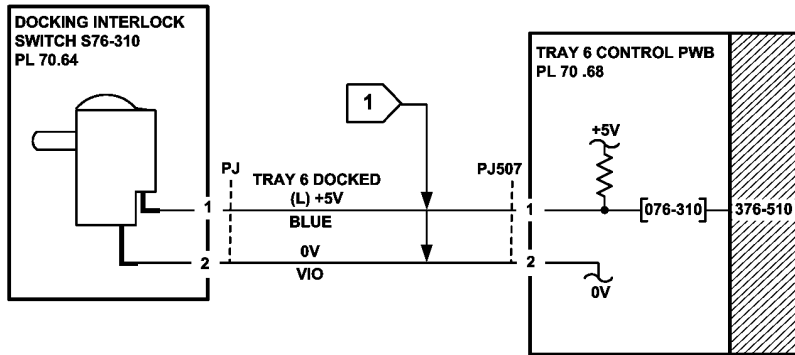
TRAY 6 CONTROL PWB

Figure 3 Circuit diagram

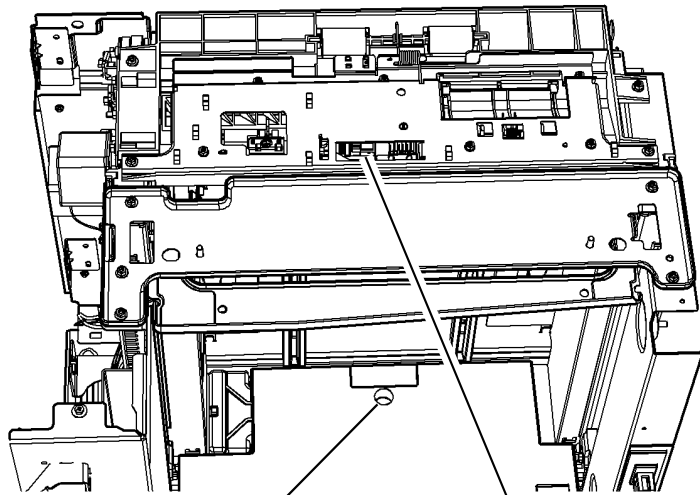
X-1-1988-A

Empty sensor Q76-320.

Check the hole in the tray is clear.

Figure 1 Component location

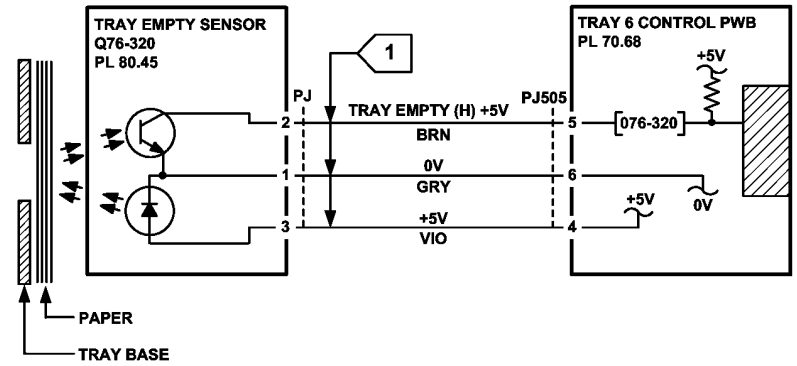
TRAY 6 CONTROL PWB

Figure 2 Circuit diagram

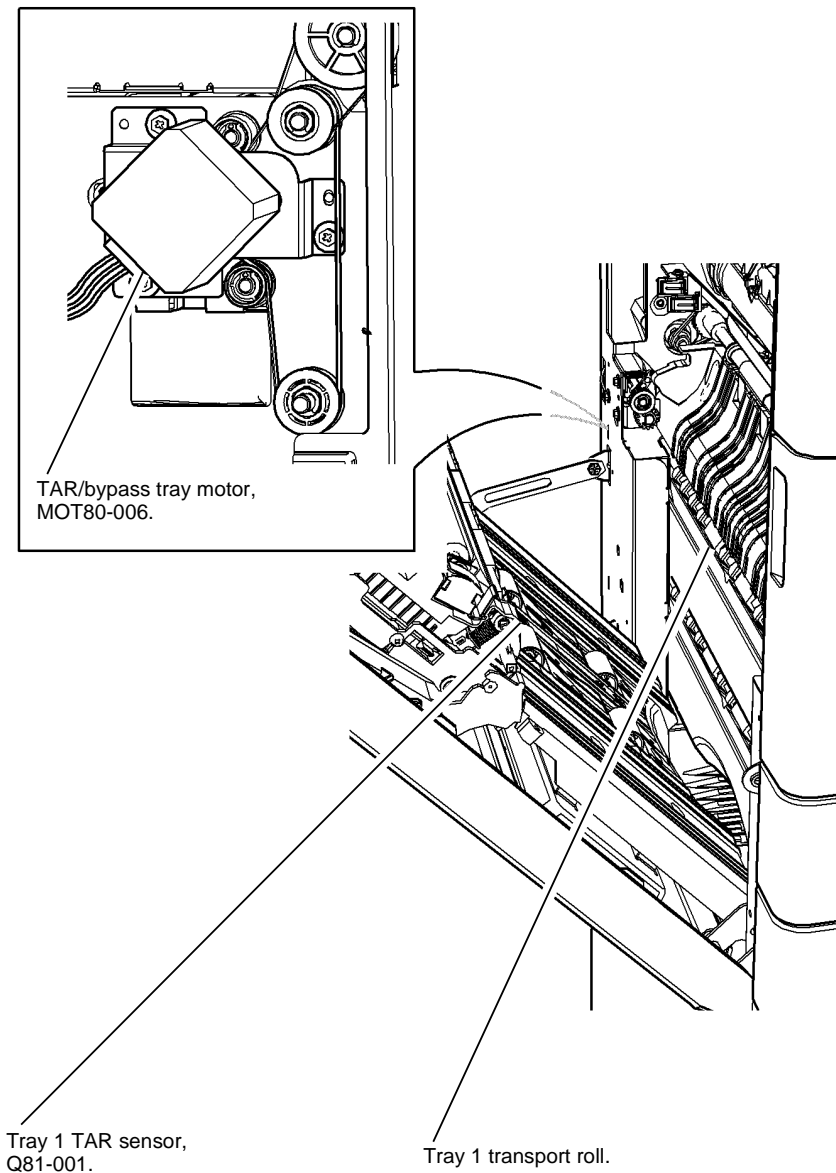
X-1-0155-A

Figure 1 Component location

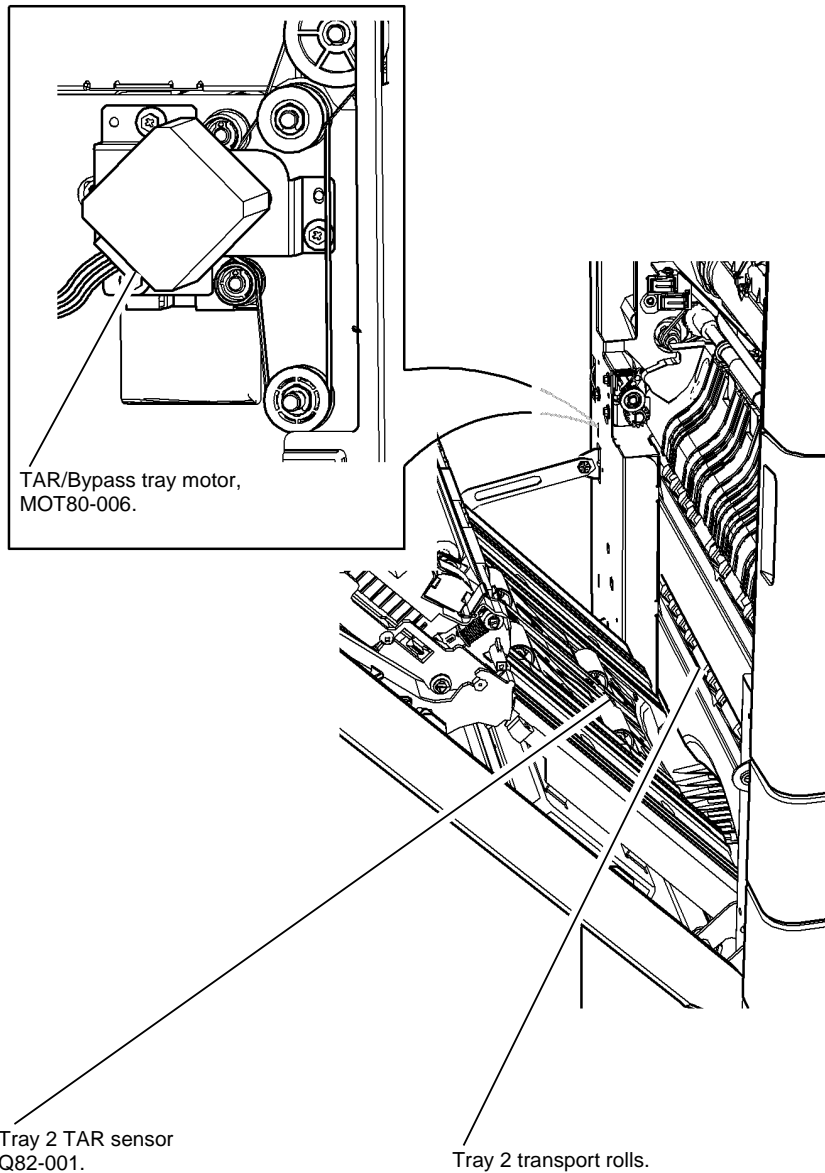
Figure 1 Component location

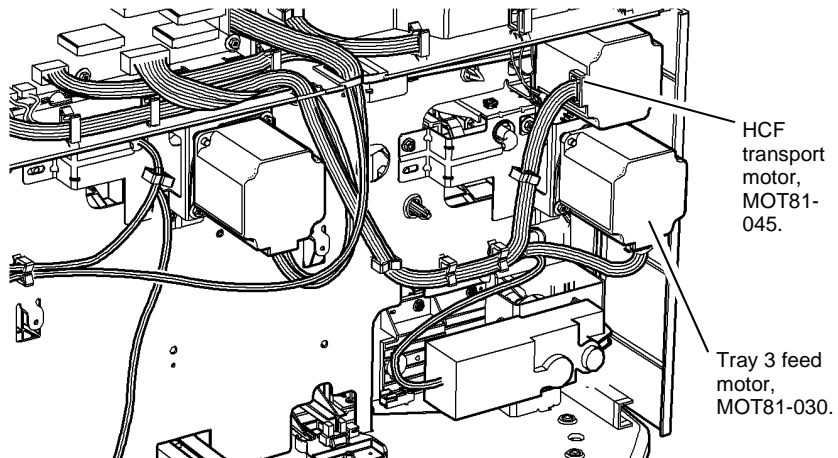
X-1-0159-A

Figure 1 Component location

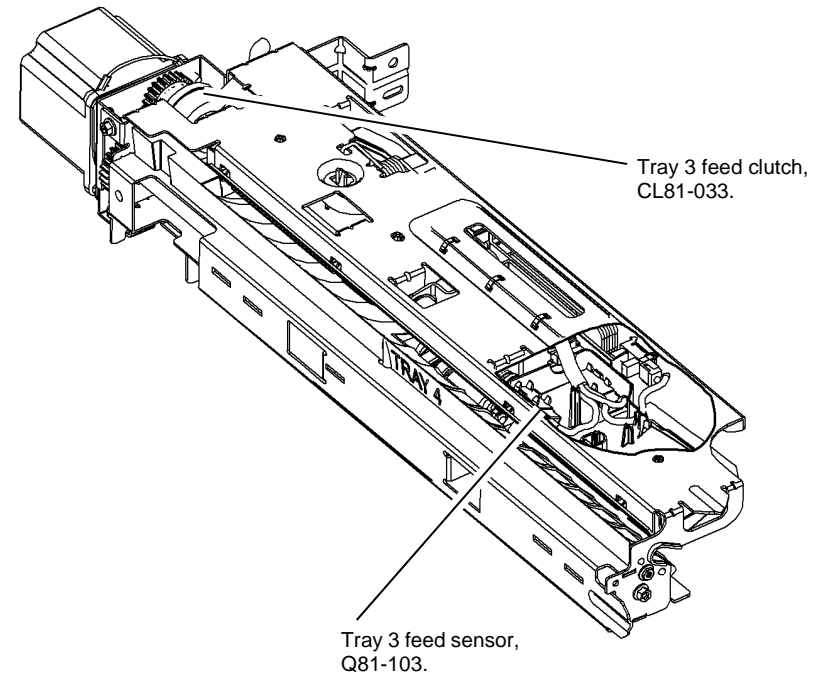
X-1-0160-A

Figure 2 Component location

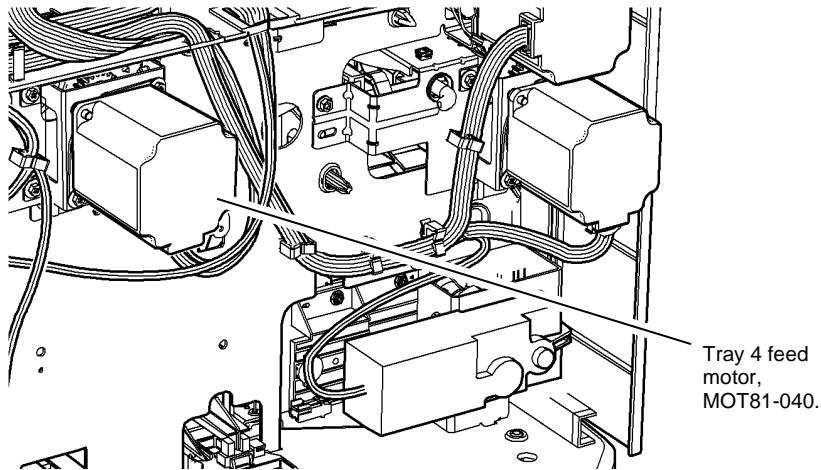
Figure 1 Component location

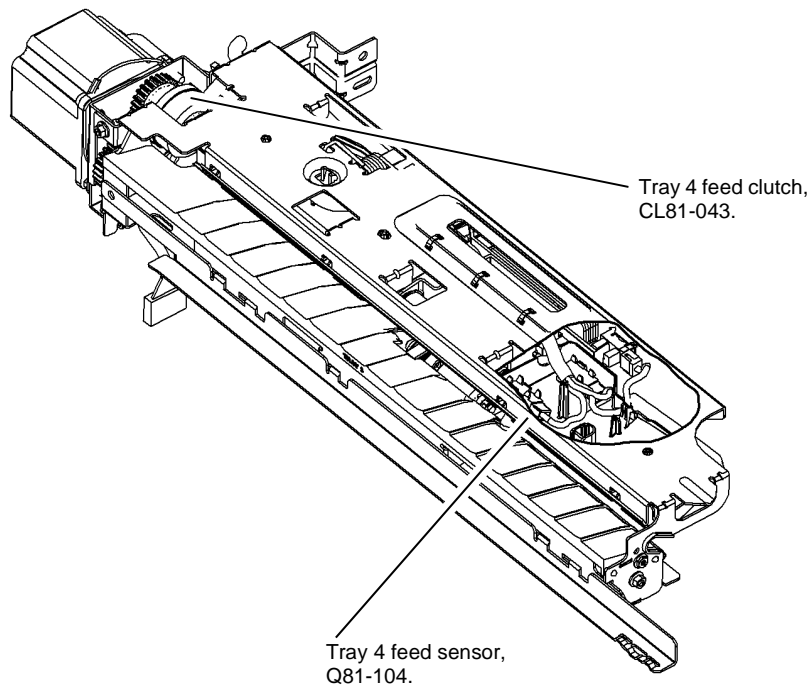
X-1-1438-A

Figure 2 Component location

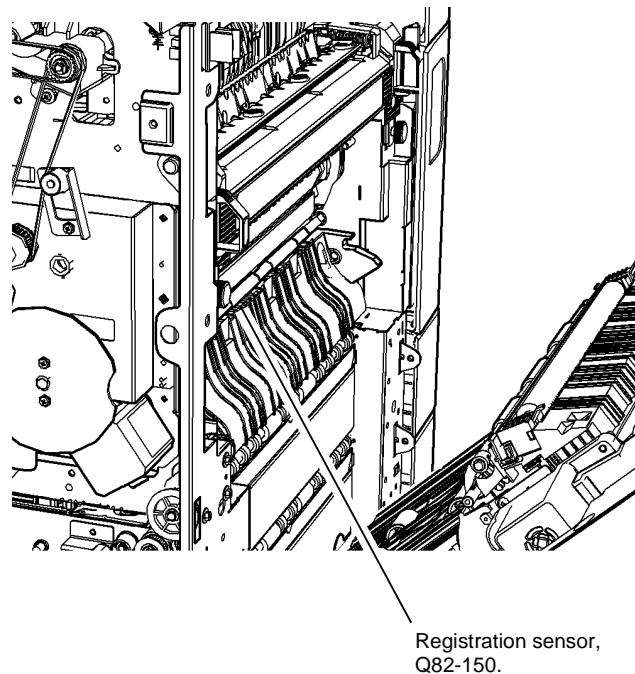
X-1-1212-A

Figure 1 Component location

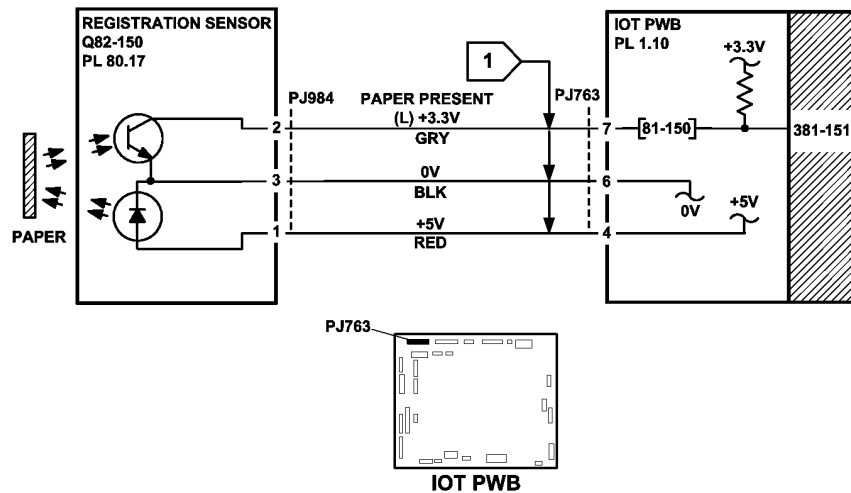
TX-1-0101-A

Figure 2 Circuit diagram

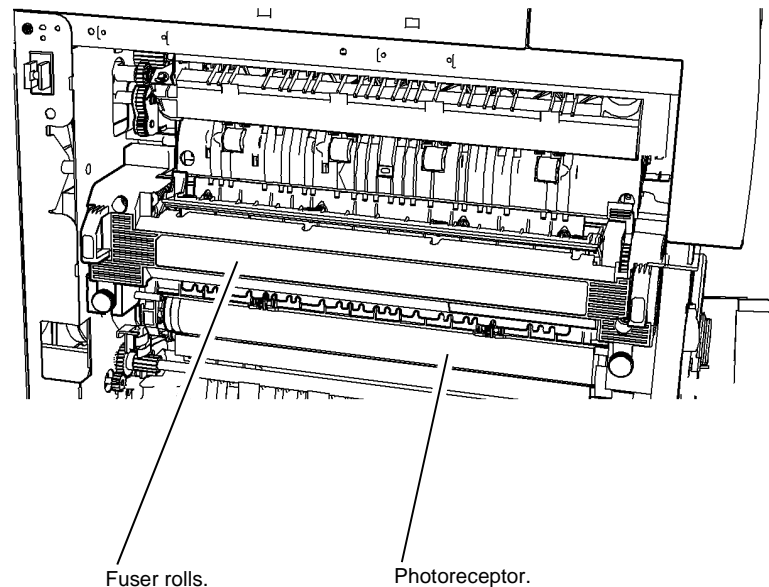
X-1-0166-A

Figure 1 Component location

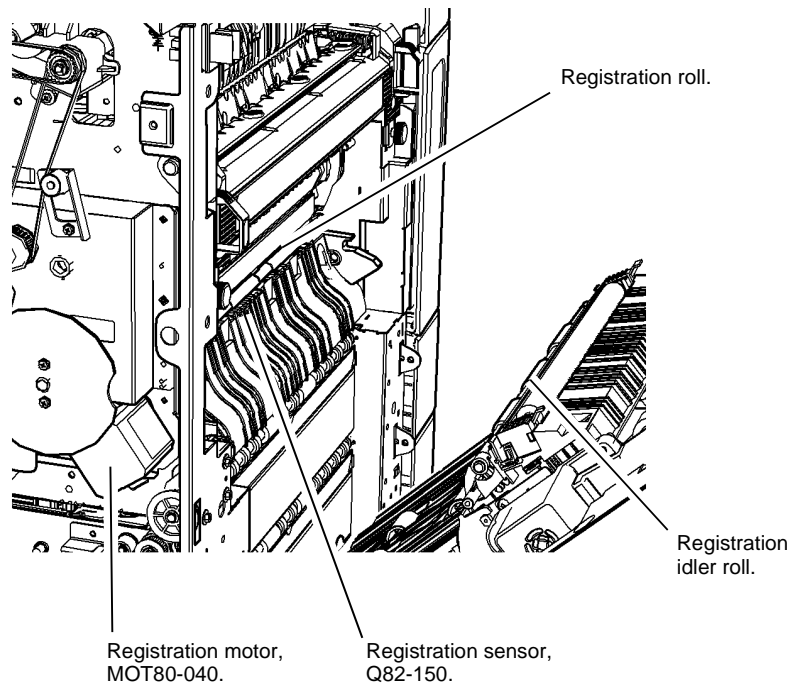
X-1-1213-A

Figure 2 Component location

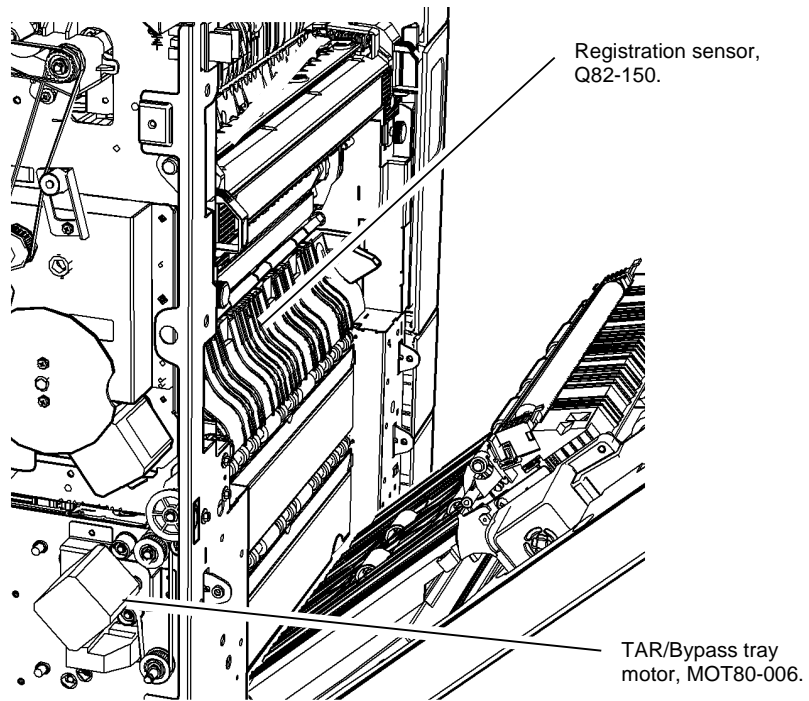
X-1-1215-A

Figure 1 Component location

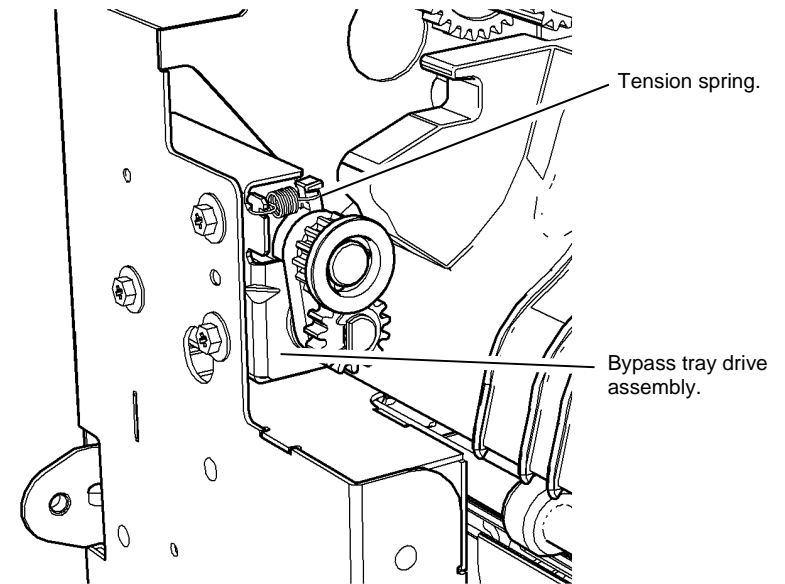
X-1-1214-A

Figure 2 Component location

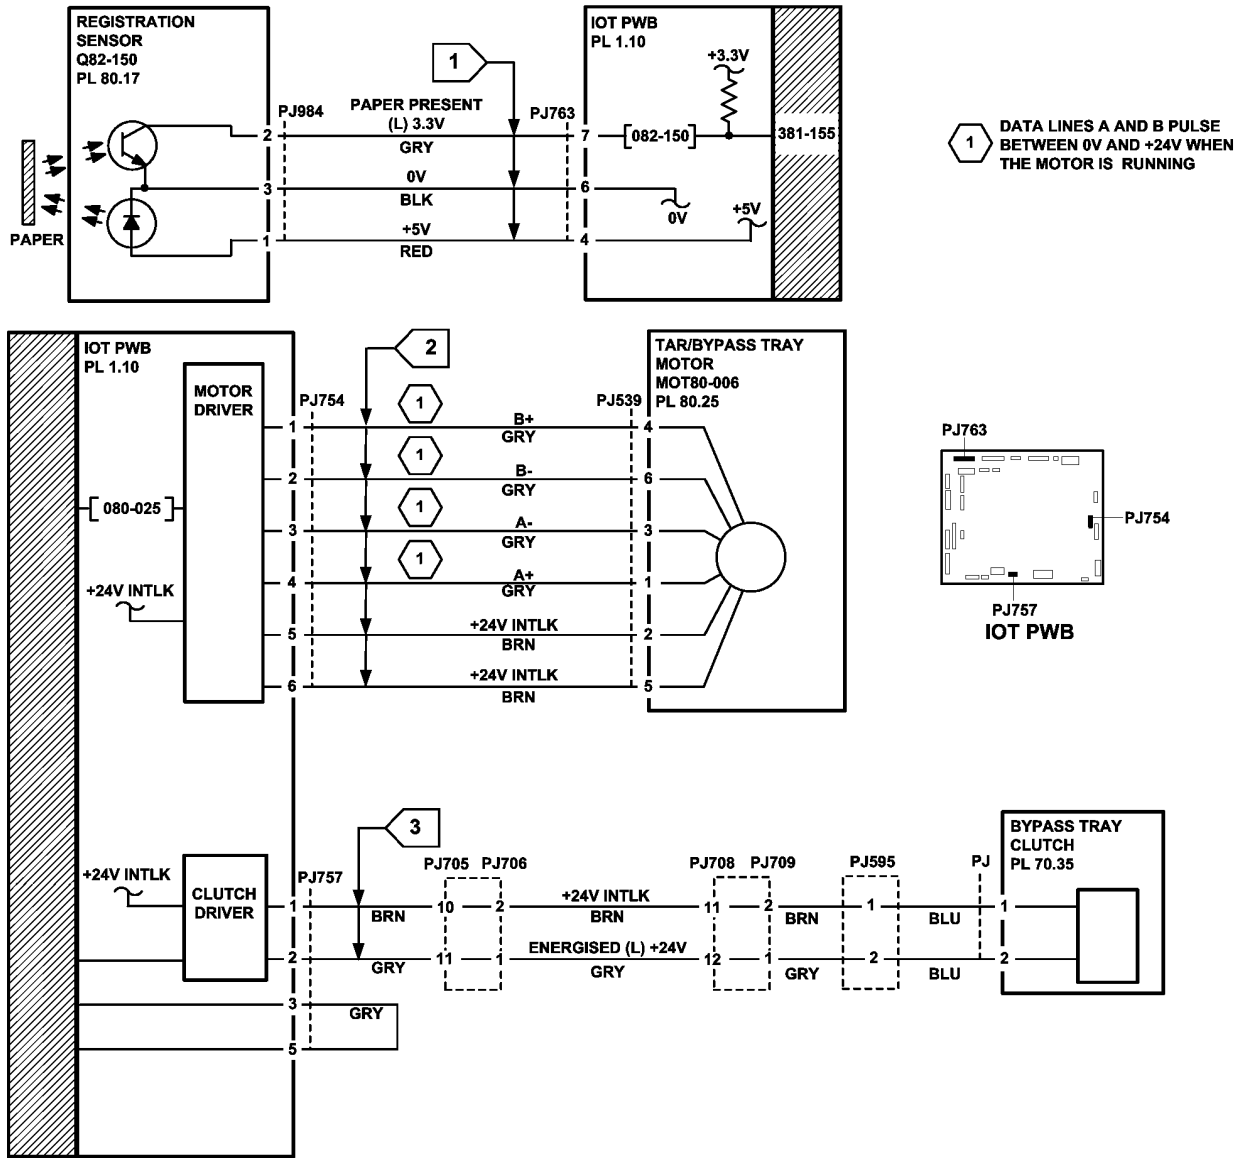
Figure 3 Circuit diagram

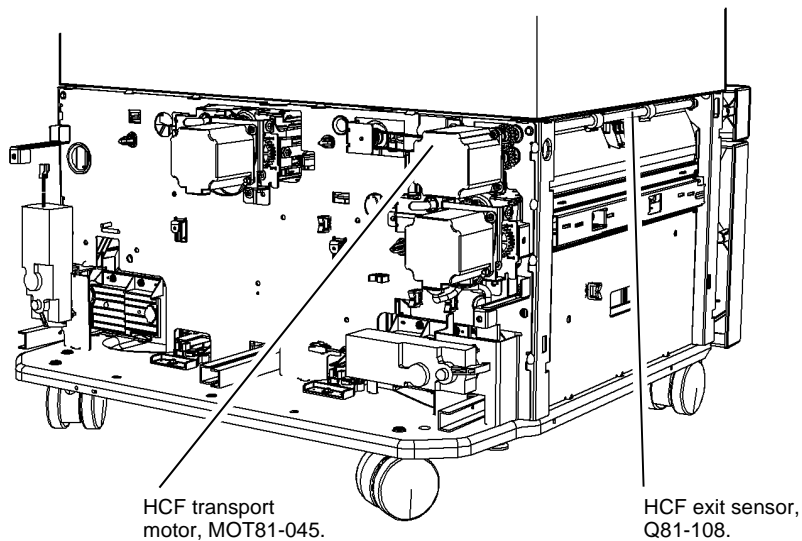
X-1-1253-A

Figure 1 Component location
