708P91368
September 2017

Xerox® AltaLink® B8090 Family Multifunction Printer Service Manual

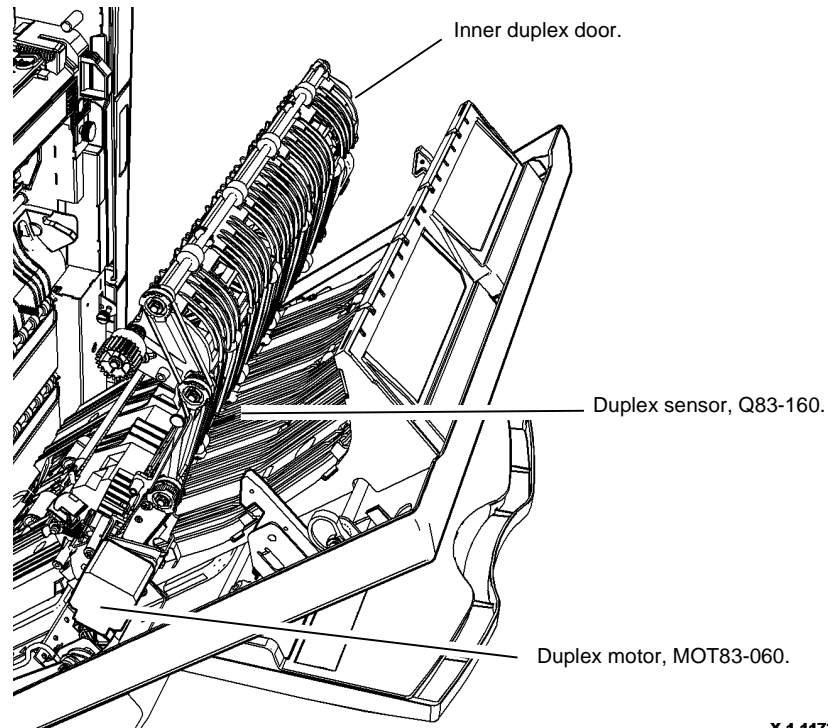
X-1-1173-A

Figure 1 Component location

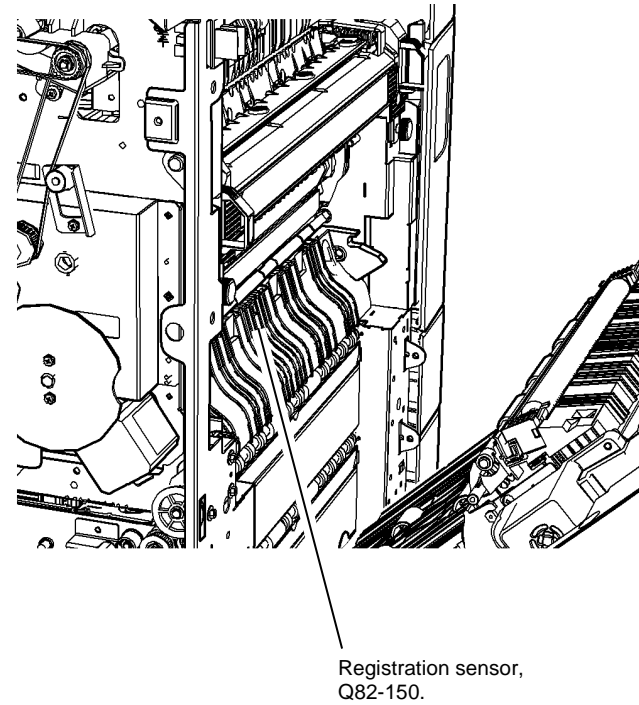
X-1-1217-A

Figure 2 Component location

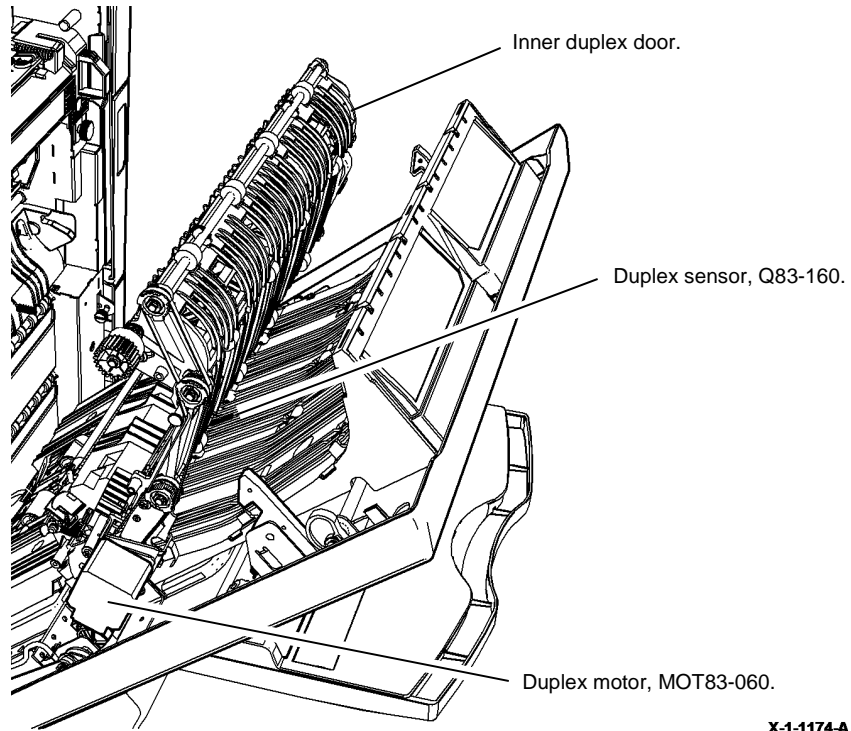
X-1-1174-A

Figure 1 Component location

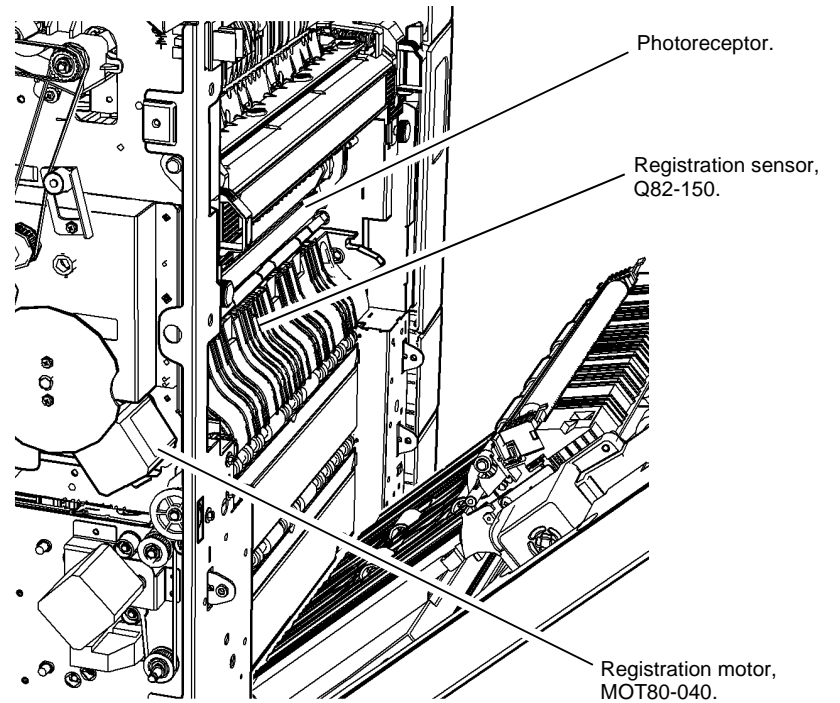
X-1-1216-A

Figure 2 Component location

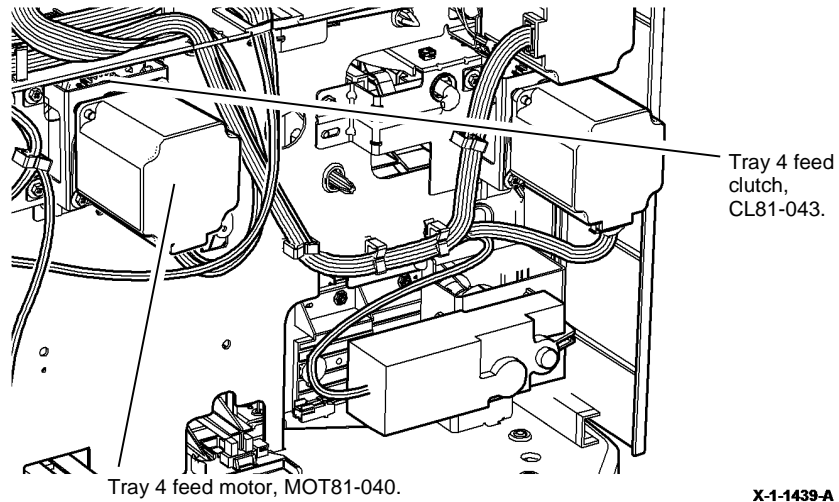
X-1-1439-A

Figure 1 Component location

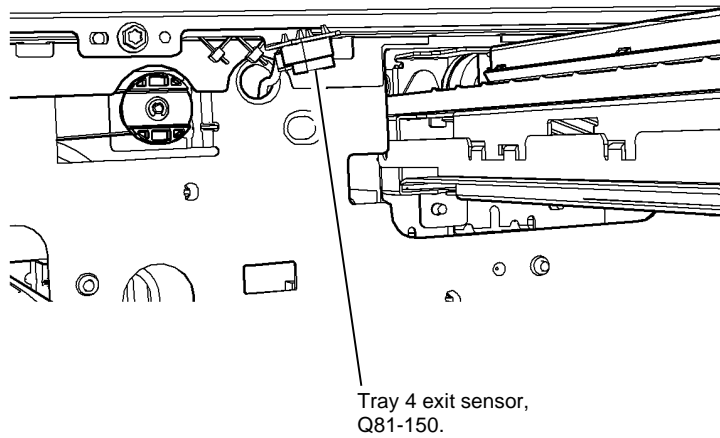
X-1-1440-A

Figure 2 Component location

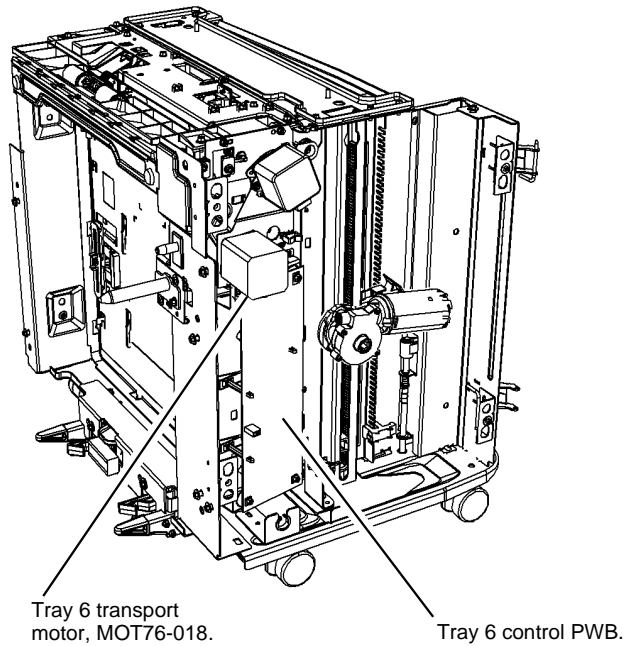
X-1-1995-A

Figure 1 Component location

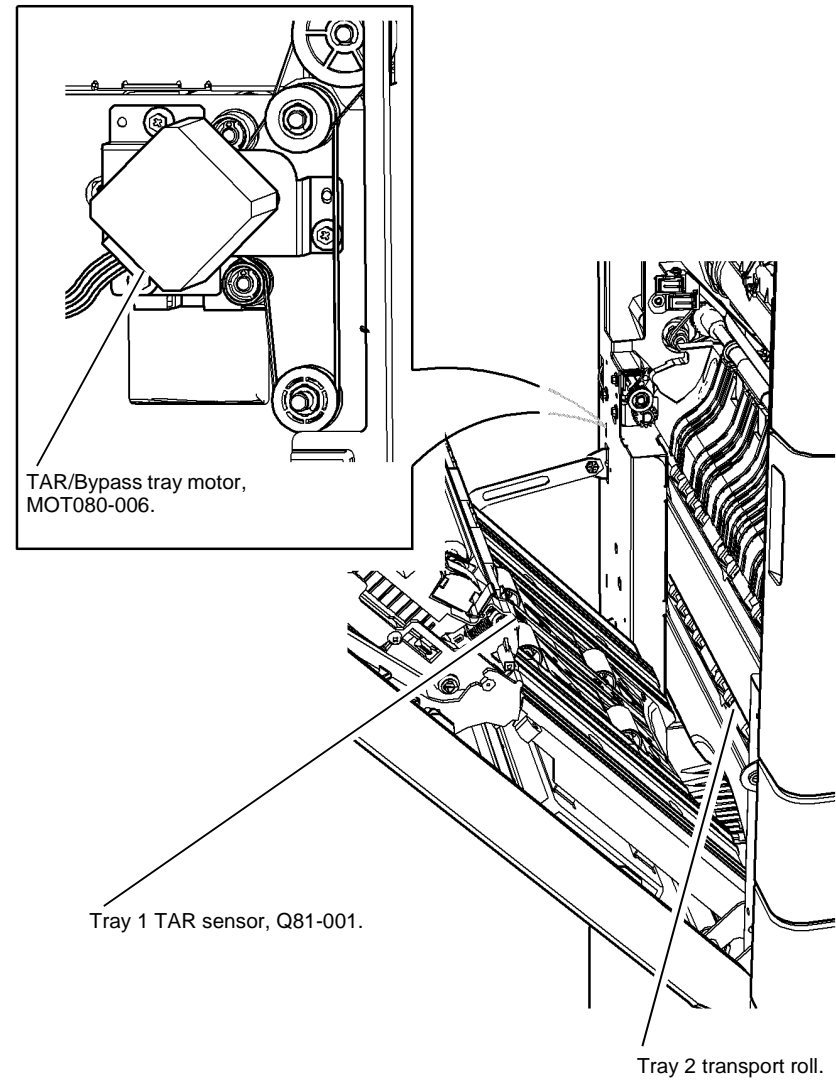
X-1-1994-A

Figure 2 Component location

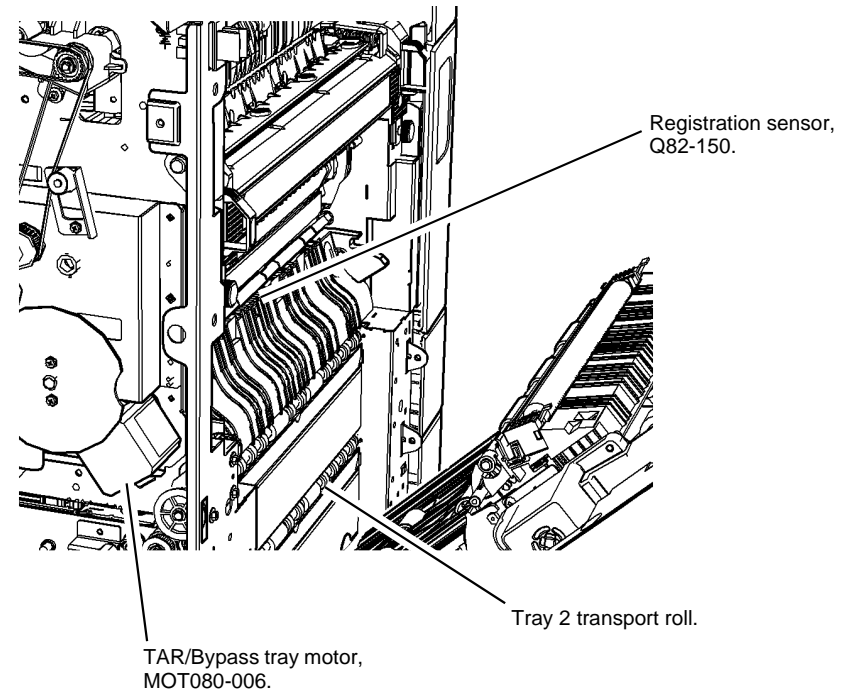
X-1-1996-A

Figure 1 Component location

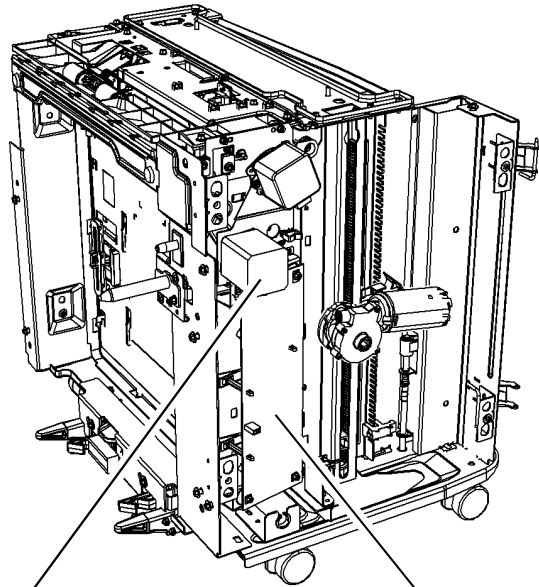
X-1-1997-A

Tray 6 transport
motor, MOT76-018.

Tray 6 control PWB.

Figure 2 Component location

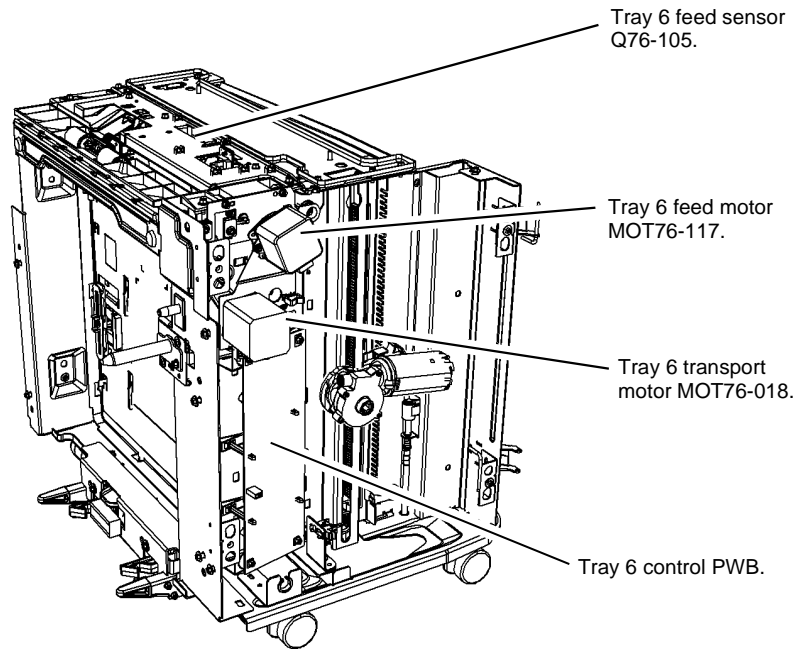
X-1-1998-A

Figure 1 Component location

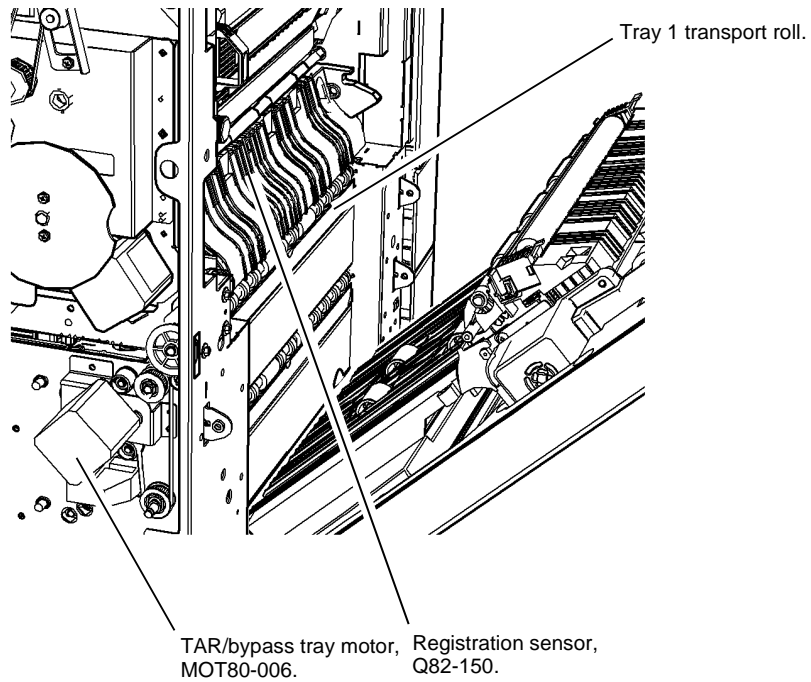
X-1-1256-A

Figure 1 Component location

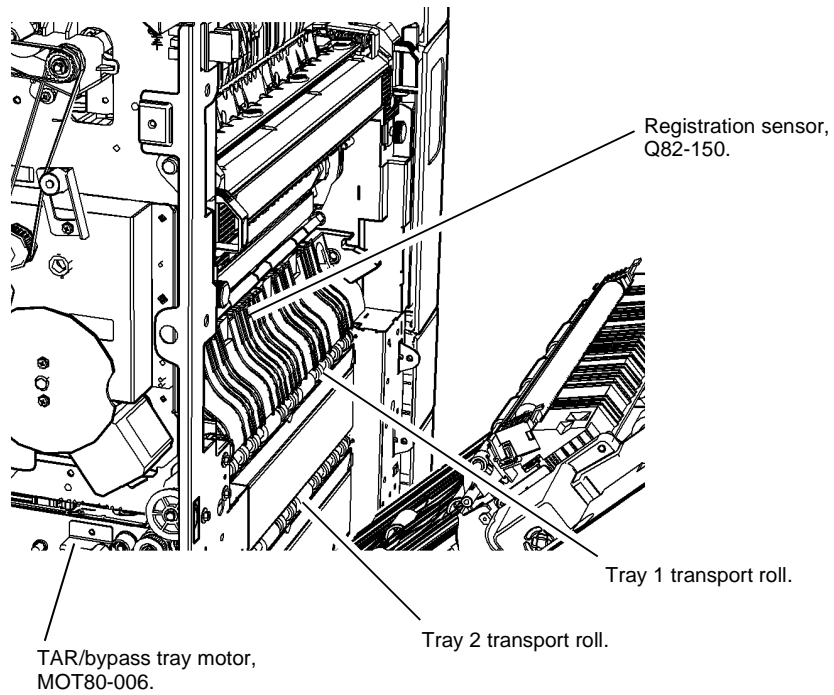
X-1-1257-A

Figure 1 Component location

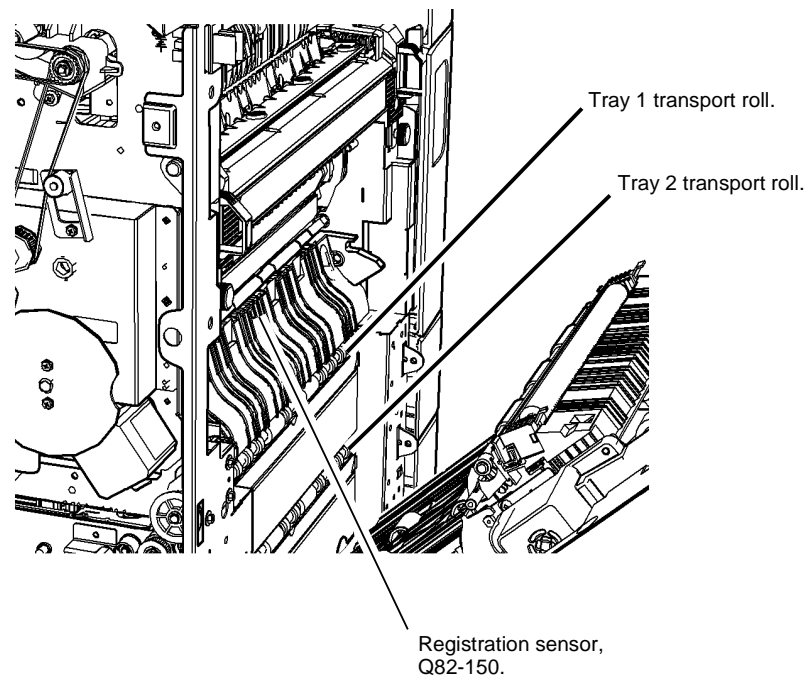
X-1-1259-A

Figure 1 Component location

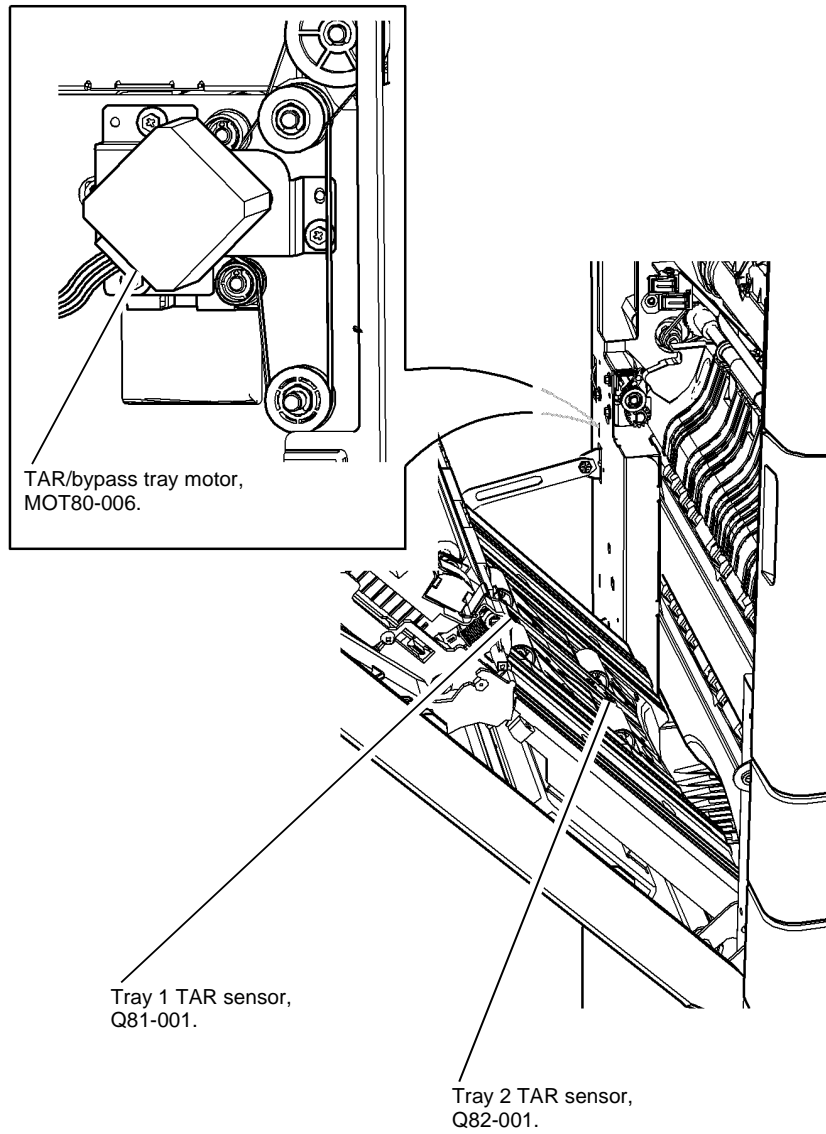
X-1-1266-A

Figure 2 Component location

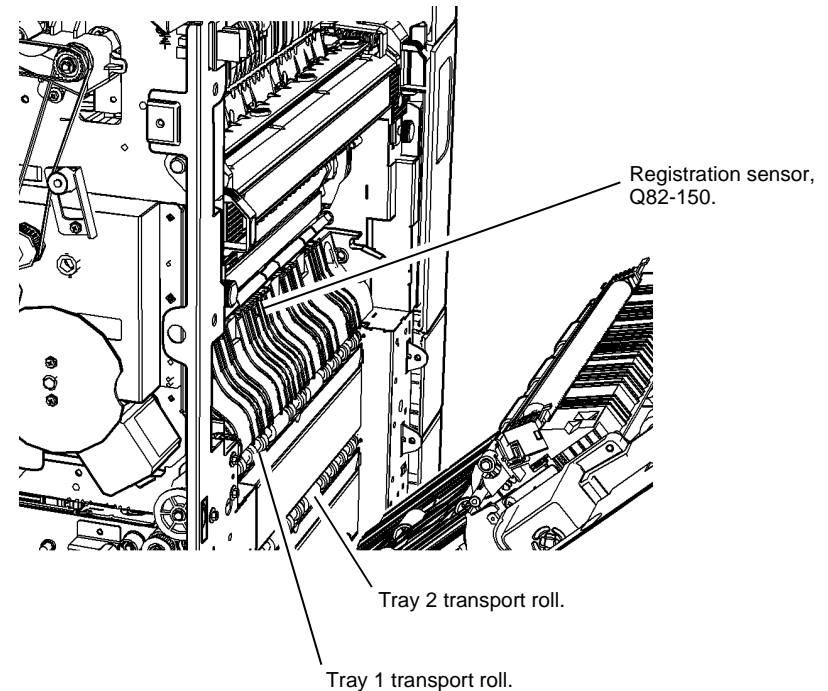
X-1-1267-A

Figure 1 Component location

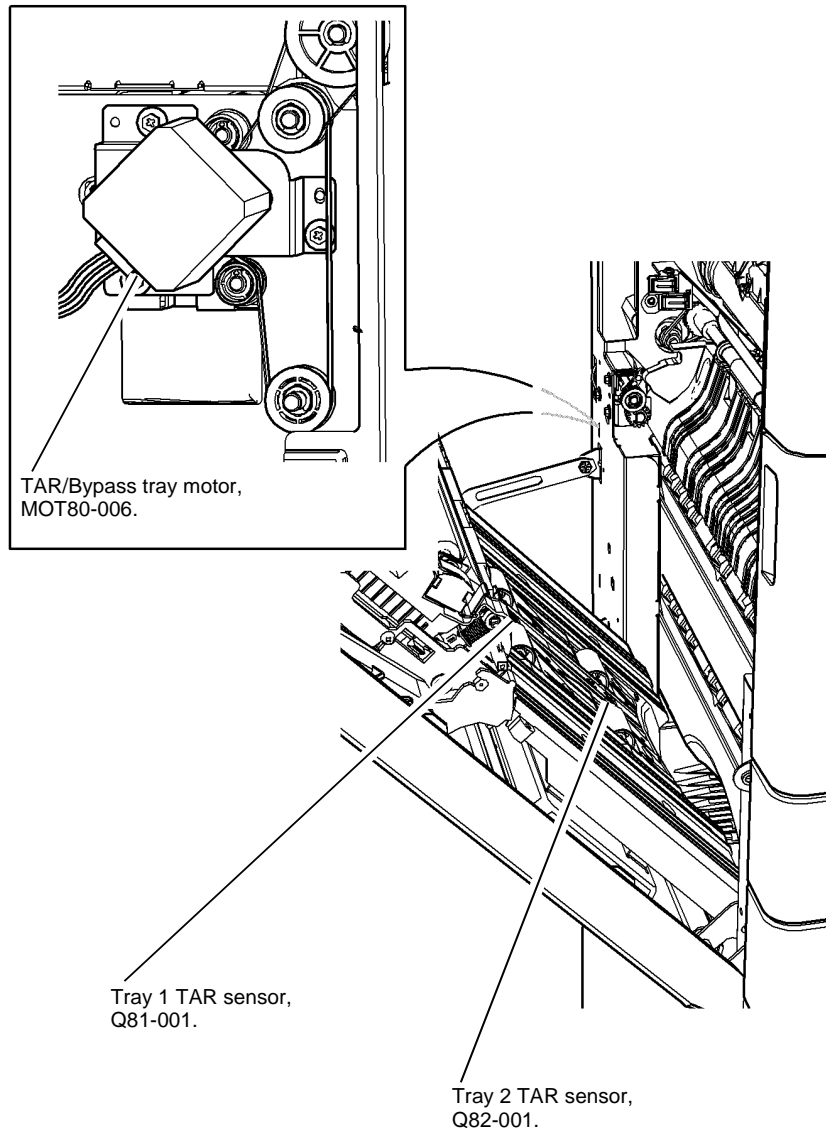
X-1-1268-A

Figure 2 Component location

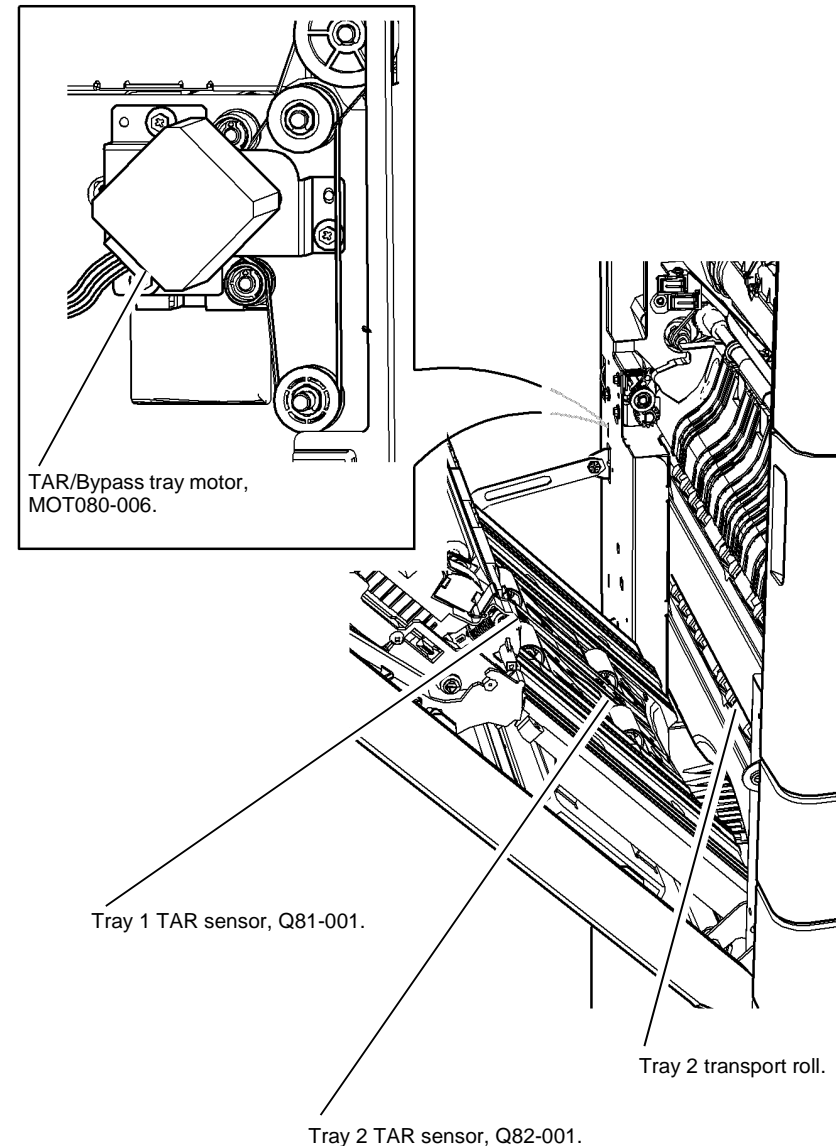
X-1-1269-A

Figure 1 Component location

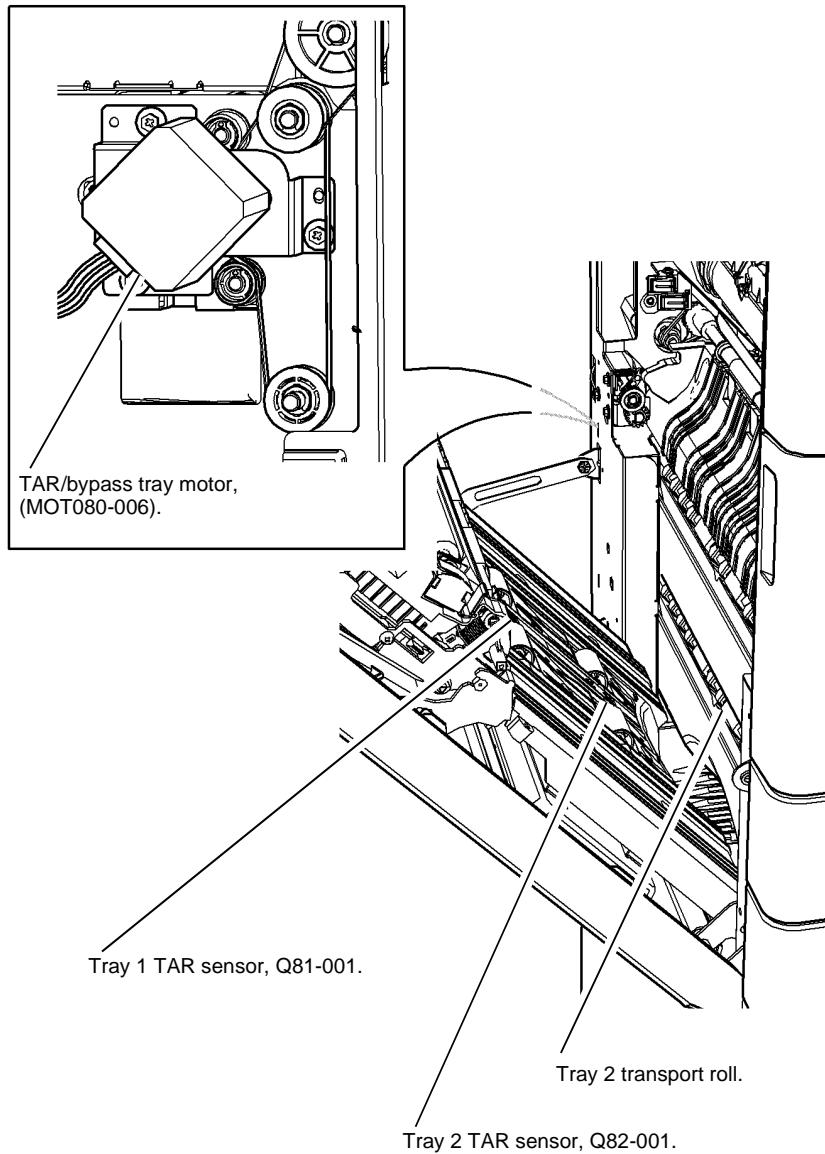
X-1-1270-A

Figure 1 Component location

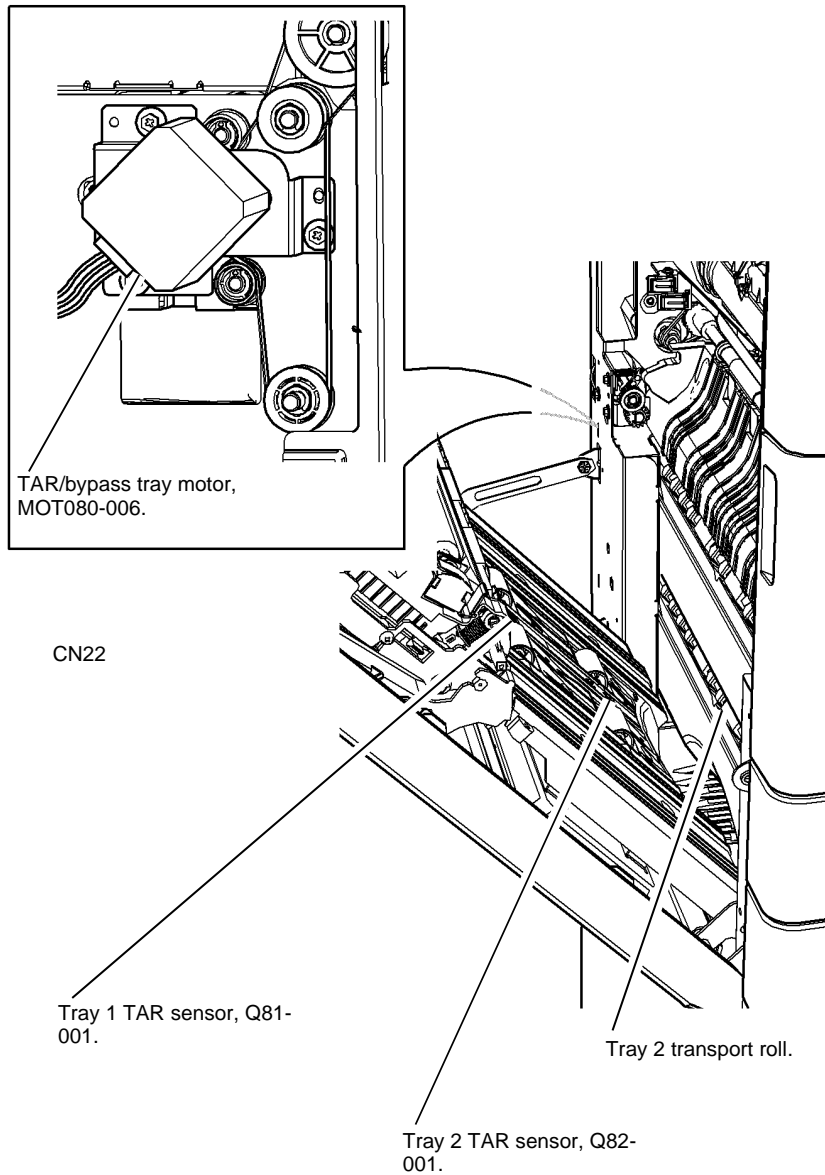
X-1-1271-A

Figure 1 Component location

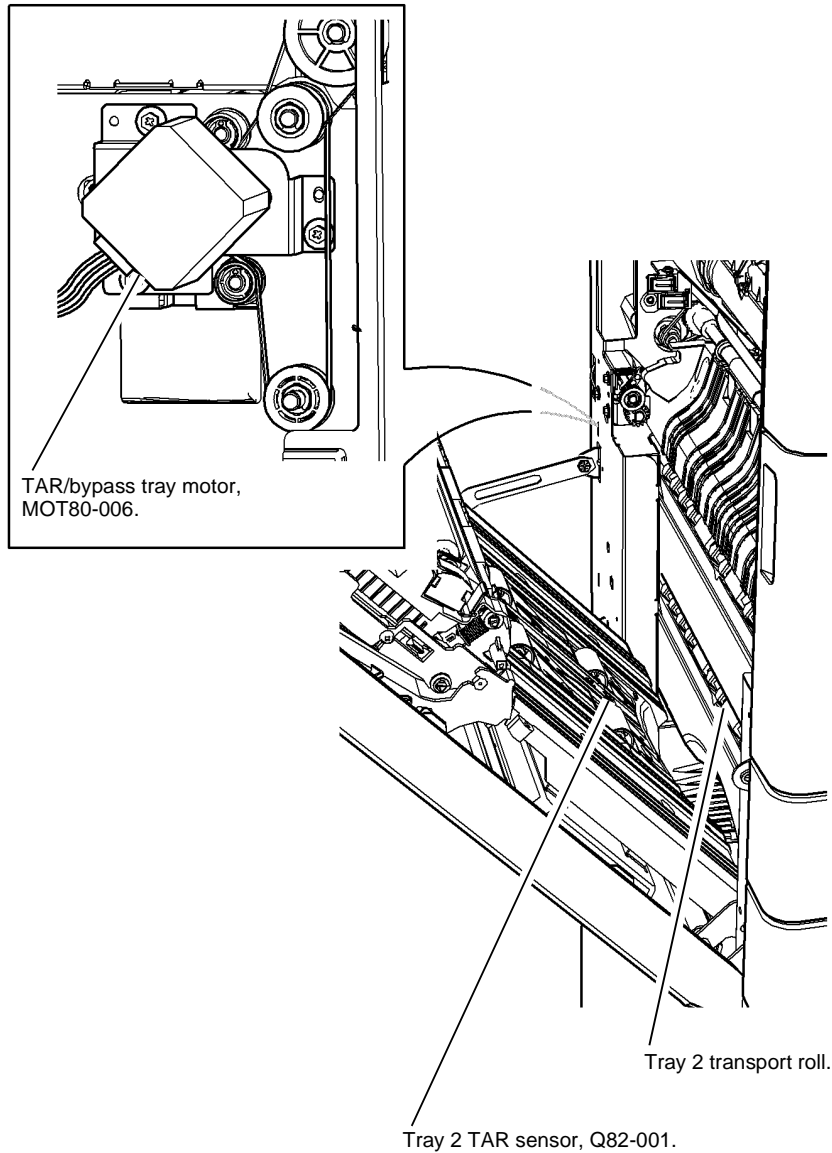
X-1-1272-A

Figure 1 Component location

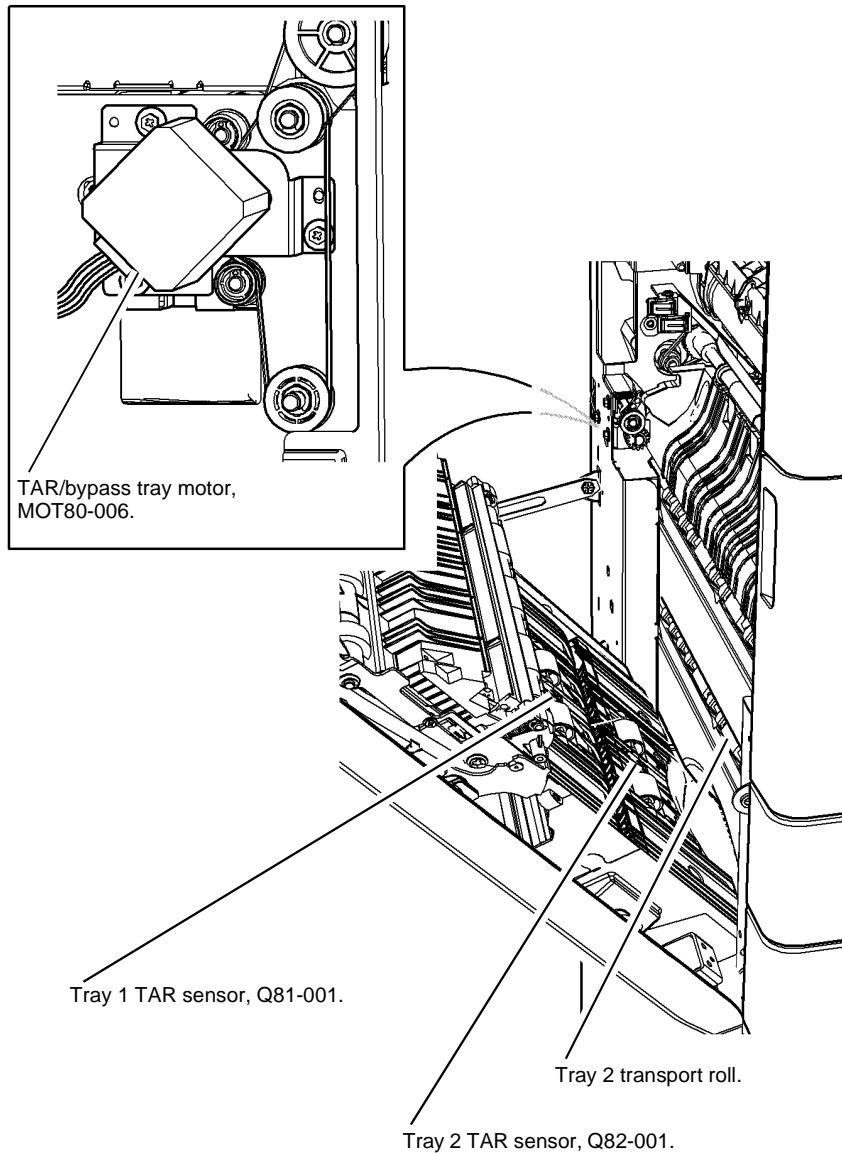
X-1-1273-A

Figure 1 Component location

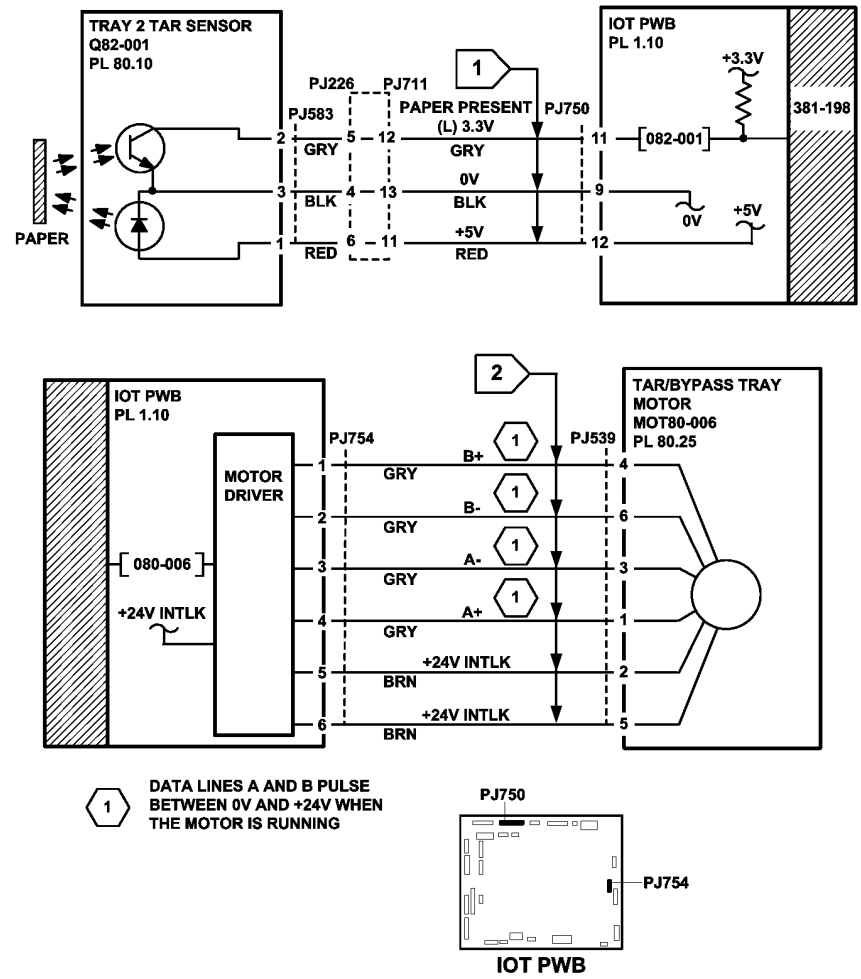
TX-1-0320-A

Figure 2 Circuit diagram

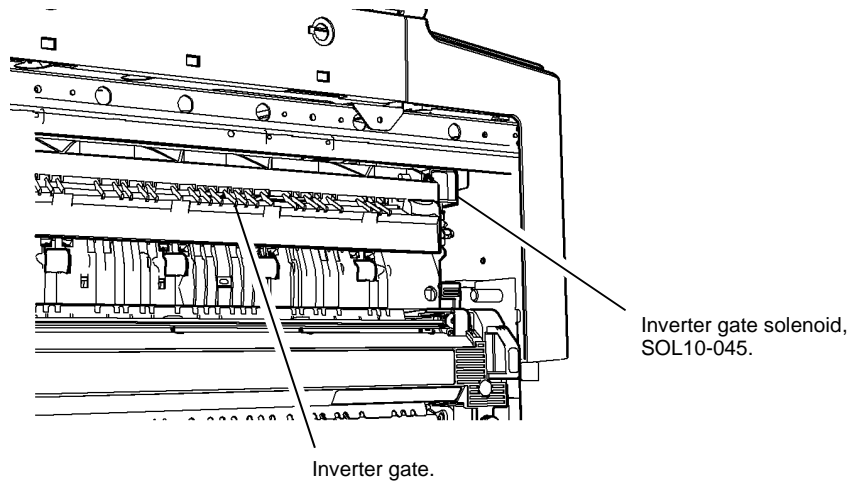
W-1-1427-A

Figure 2 Component location

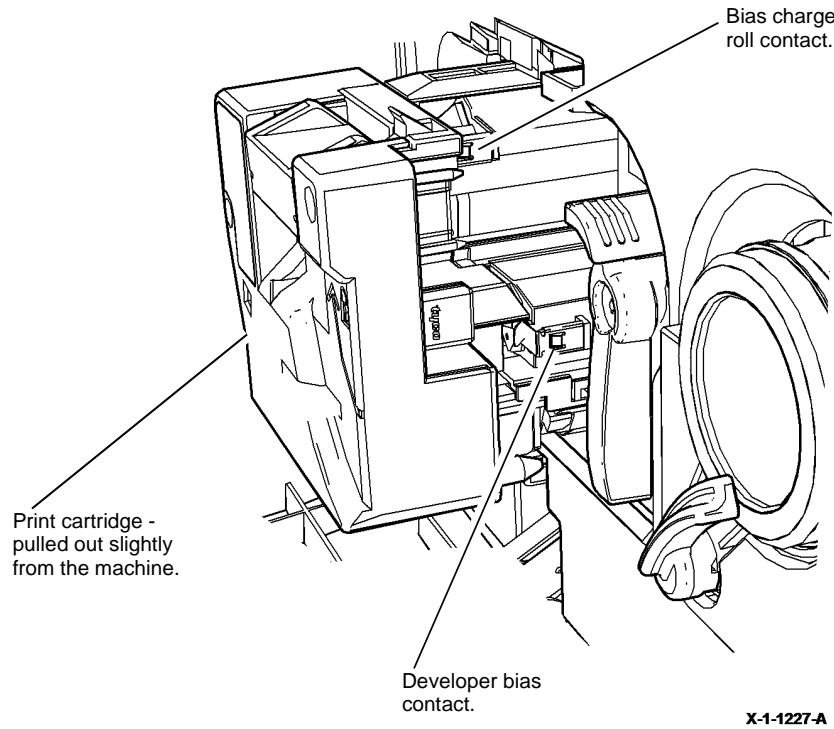
Figure 1 Component location

- Track (BCR) on the HVPS tray assembly for continuity, short circuits and damage. Ensure the contact area at each end is clean and undamaged.
- The BCR contact on the HVPS is clean and undamaged, Figure 3.
- The bias charge roll contact on the print cartridge is clean and undamaged, Figure 1.

- Track (DEV) on the HVPS tray assembly for continuity, short circuits and damage. Ensure the contact area at each end is clean and undamaged.
- The DB contact on the HVPS is clean and undamaged, Figure 3.
- The developer bias contact on the print cartridge is clean and undamaged, Figure 1.

- Track (BTR) on the HVPS tray assembly for continuity, short circuits and damage. Ensure the contact area at each end is clean and undamaged.
- The BTR contact on the HVPS is clean and undamaged, Figure 3.
- The bias transfer contact on the registration transfer housing is clean and undamaged, Figure 1.
- The condition of the bias transfer roll and bearings, Figure 2.

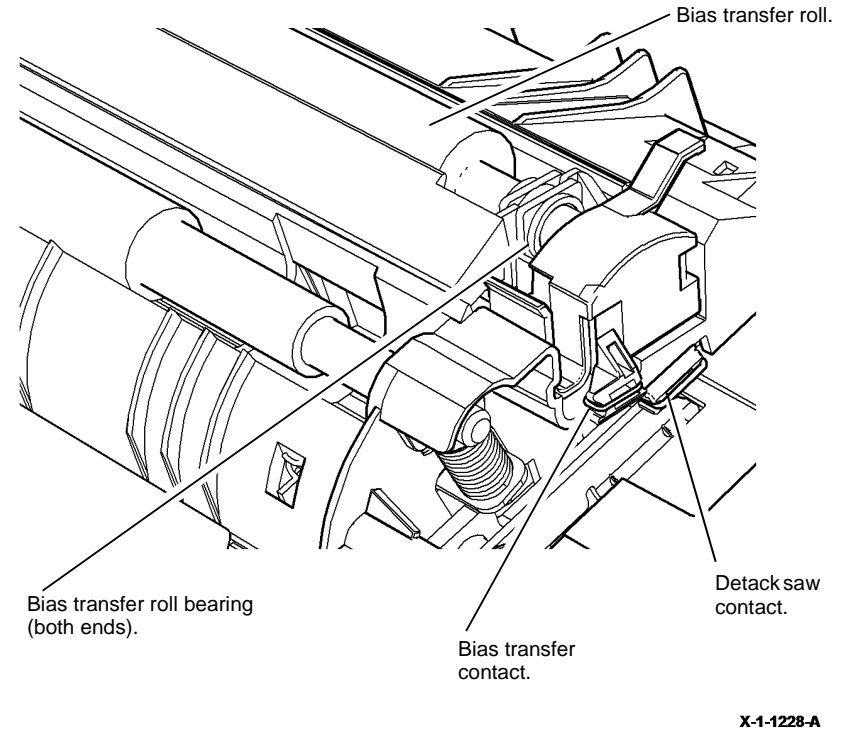
Figure 2 Component Location

- Track (DTS) on the HVPS tray assembly for continuity, short circuits and damage. Ensure the contact area at each end is clean and undamaged.
- The DTS contact on the HVPS is clean and undamaged, Figure 3.
- The detach saw contact on the registration transfer housing is clean and undamaged, Figure 2.

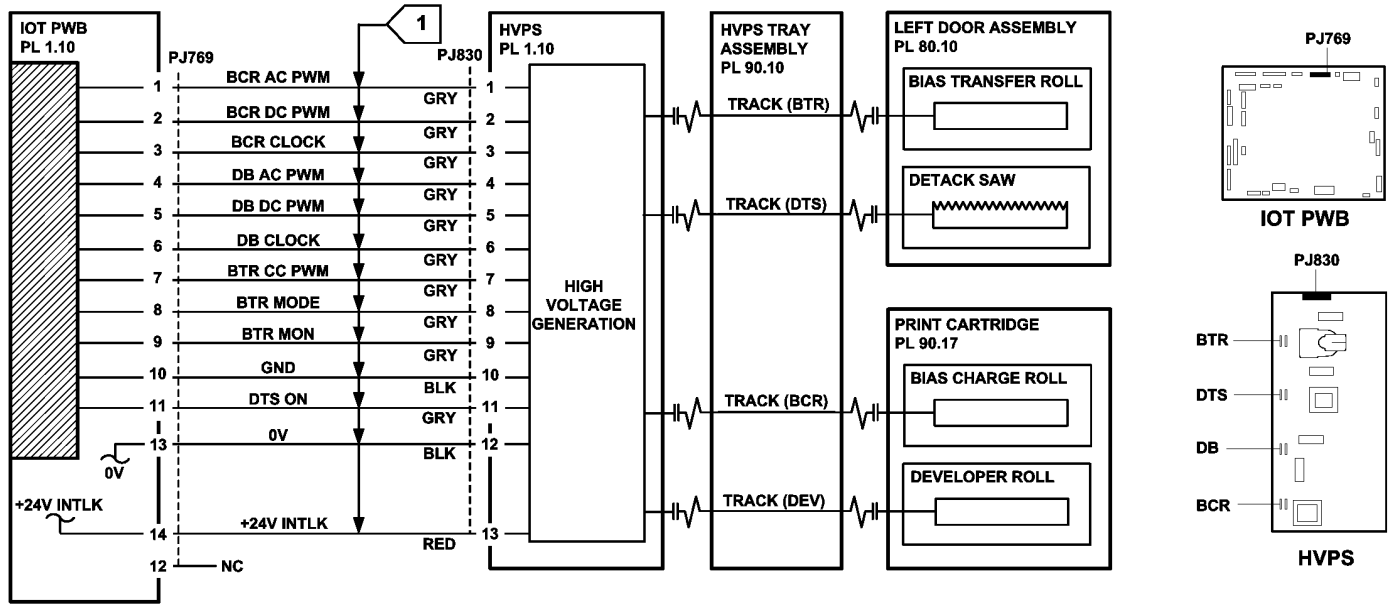
TX-1-0300-A

Figure 3 Circuit diagram

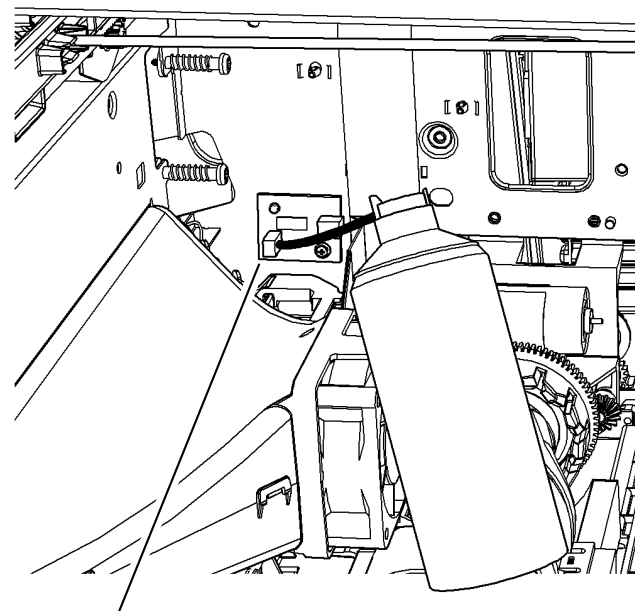
X-1-1354-A

Humidity sensor (Q91-601), part of the environmental sensors PWB.

Figure 1 Component location

Open the left side door. Remove the print cartridge, [PL 90.17 Item 9](#), and the fuser module, [PL 10.8 Item 1](#). Enter [dC140](#) code 091-601, humidity sensor, Q91-601. Observe the displayed state of Q91-601. Use an air duster, [PL 26.11 Item 1](#), directed onto the environmental sensors PWB to change the state of Q91-601, [Figure 1](#).

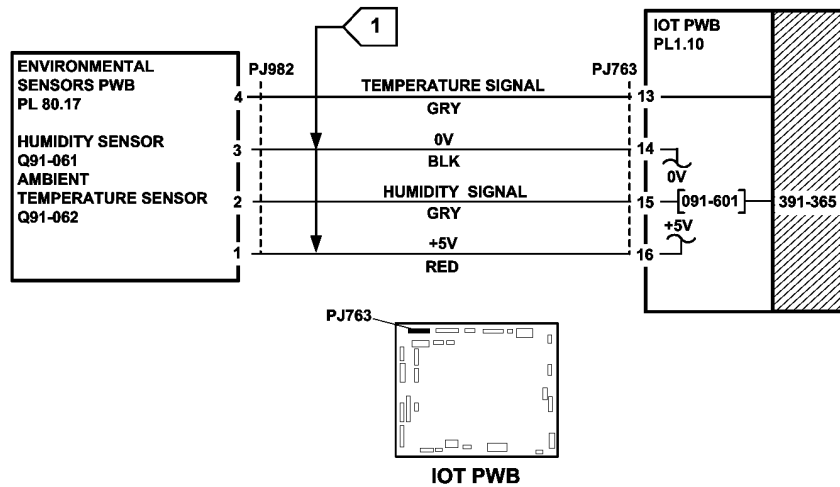
TX-1-0277-A

Figure 2 Circuit diagram

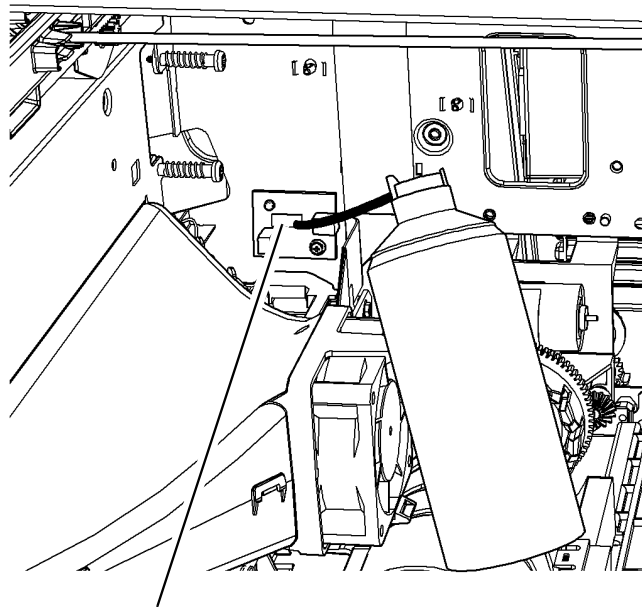
X-1-1355-A

Ambient temperature sensor (Q91-062),
part of the environmental sensors PWB.

Figure 1 Component location

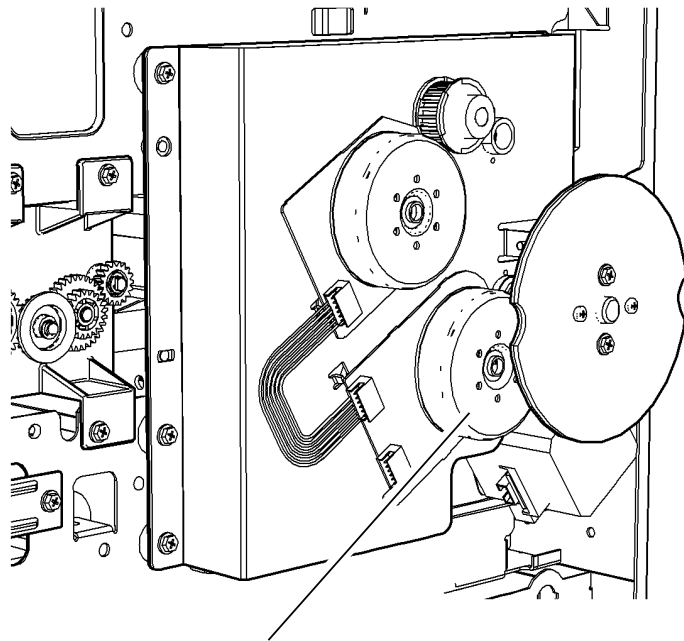
X-1-1164-A

Print cartridge
motor, MOT93-045

Figure 1 Component location

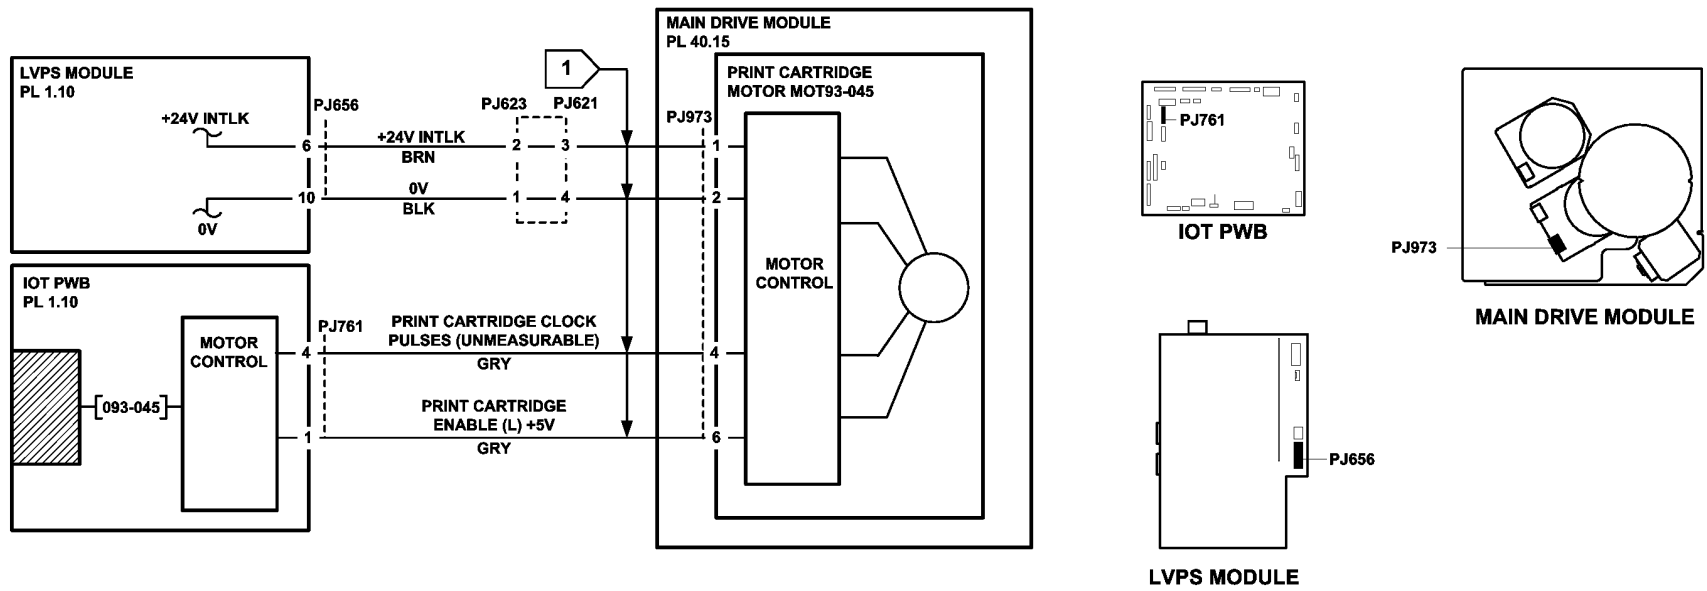
TX-1-0295-A

Figure 2 Circuit diagram

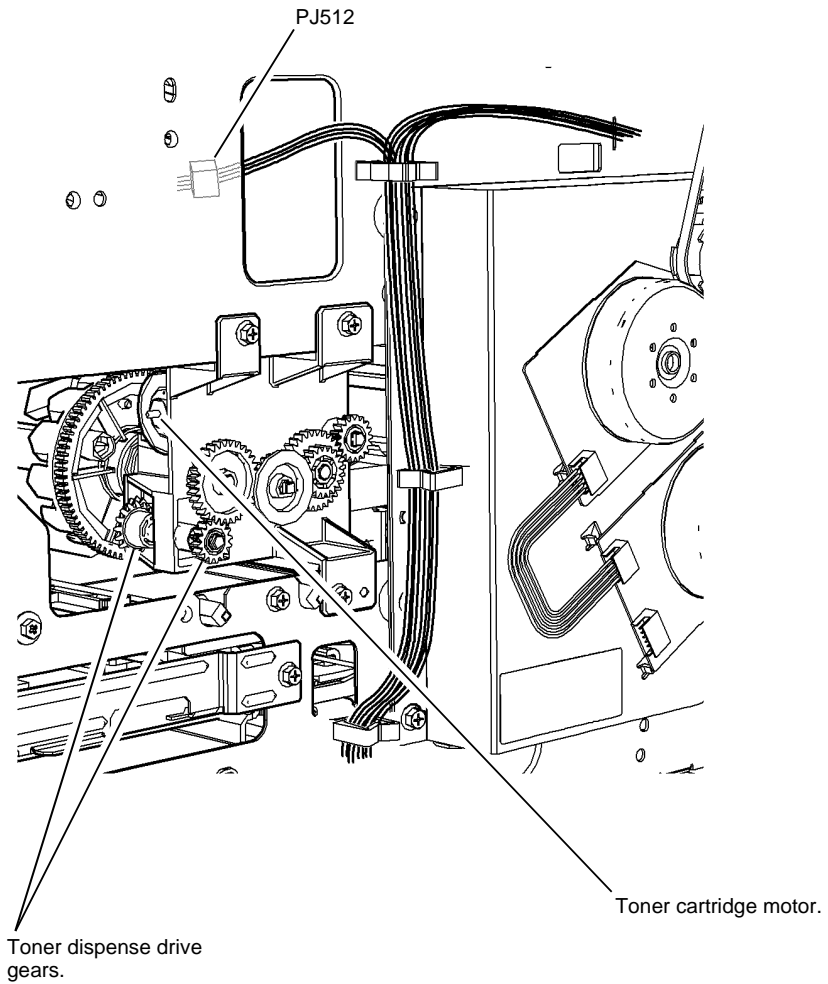
X-1-1098-A

Figure 1 Toner dispense module

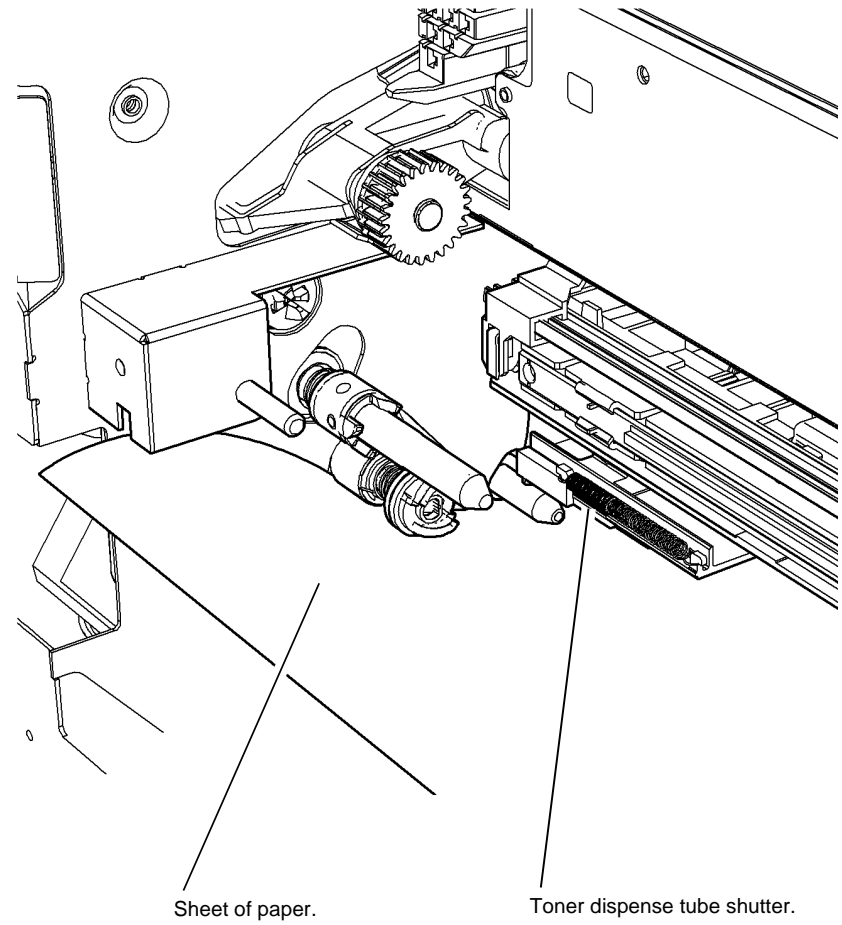
X-1-1099-A

Figure 2 Toner dispense tube
