708P91368
September 2017

Xerox® AltaLink® B8090 Family Multifunction Printer Service Manual

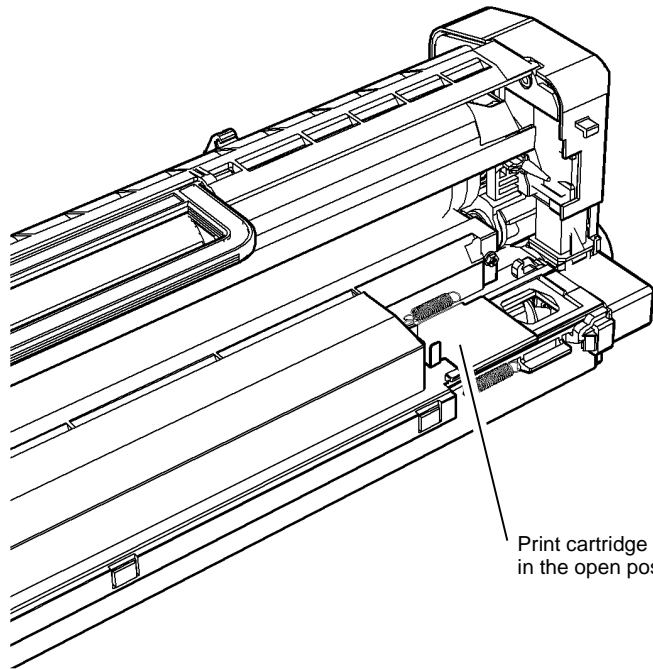
X-1-1100-A

Figure 3 Print cartridge shutter

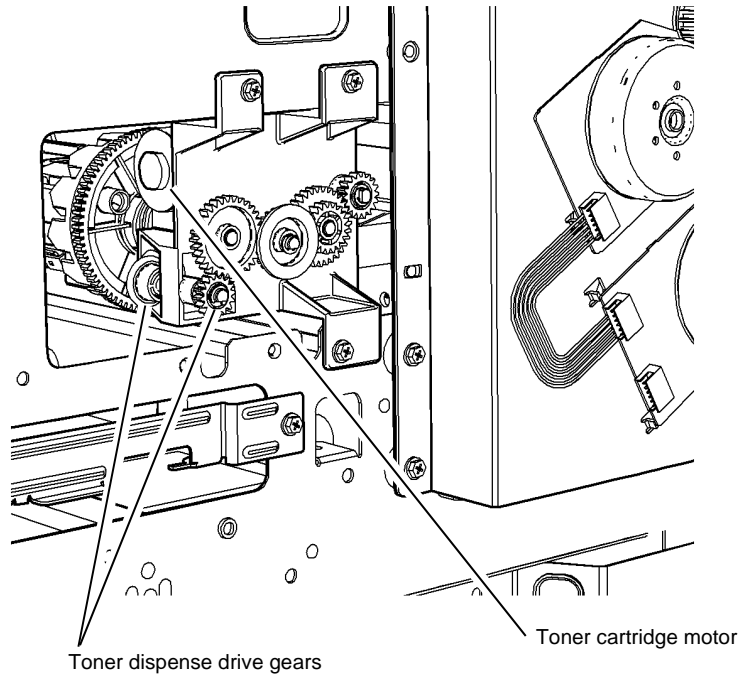
X-1-1101-A

Figure 1 Toner dispense module

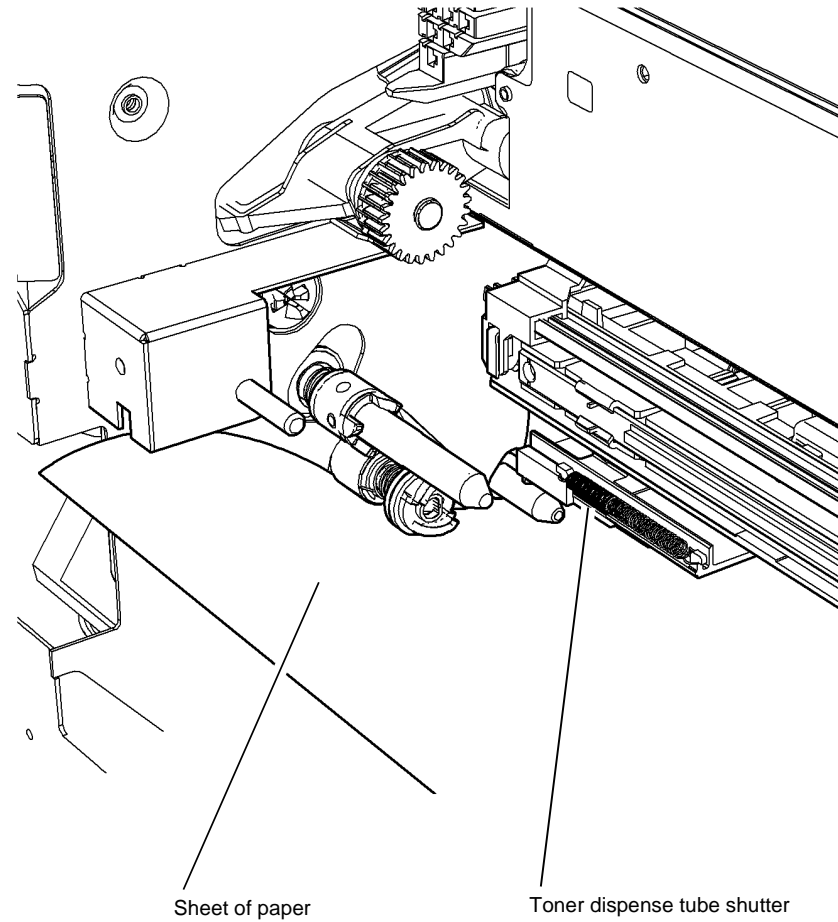
X-1-1102-A

Figure 2 Toner dispense tube

Y N
Ensure the shutter on the toner dispense tube opens and closes correctly. If necessary, install a new toner dispense module, PL 90.17 Item 1. Install a new toner cartridge, PL 90.17 Item 2.

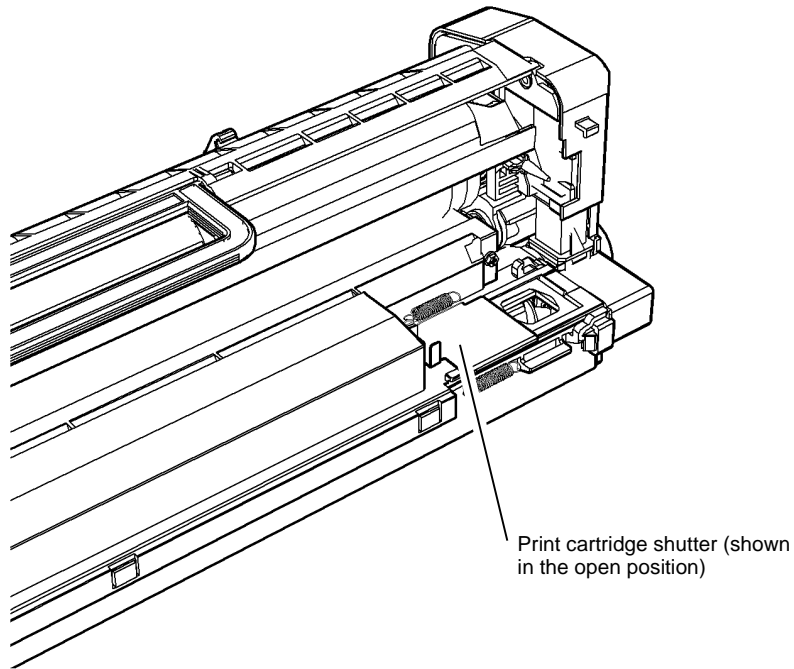
X-1-1103-A

Figure 3 Print cartridge shutter

Ensure the shutter on the print cartridge, Figure 3, opens and closes correctly. If necessary, install a new print cartridge, PL 90.17 Item 9. Install a new toner cartridge, PL 90.17 Item 2.

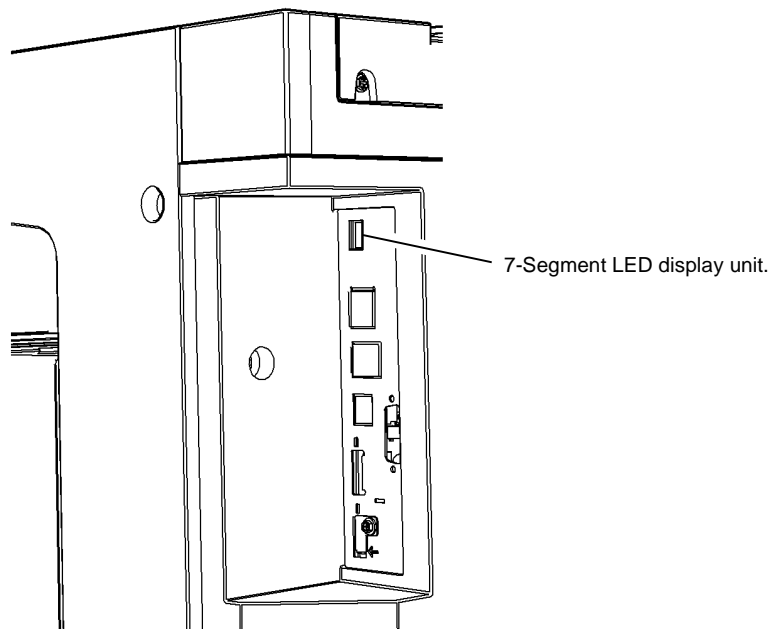
X-1-1051-A

Rear right of machine.

- POST is performed by the IOT PWB and the SBC PWB.
- The fault is communicated via a 7-Segment LED display unit on the rear of the machine attached to the SBC PWB, [Figure 1](#). This is to help diagnose common faults which prevent the machine from powering up correctly to the point where faults are displayed and service mode can be entered. The LED display should show just a pulsing decimal point when the machine boots correctly. The main codes are displayed for short periods of time during power up depending, on how long each test takes. If any code is left displayed during power up and the machine appears not to have powered on correctly, then this should indicate the problem component. Refer to [Table 1](#).

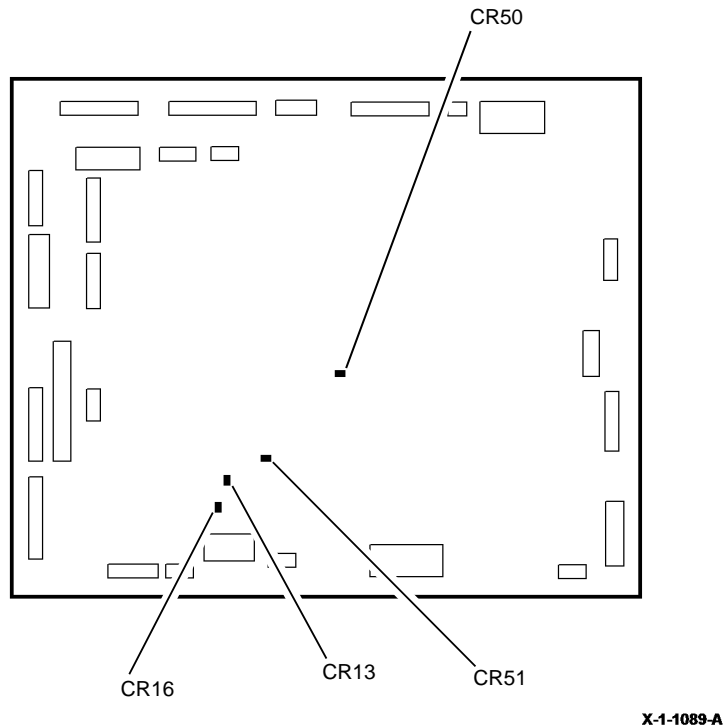
Figure 1 IOT PWB LED locations

1. Switch off, then switch on the machine, **GP 14**. With the front door and left door closed, the LEDs that follow should be observed on the IOT PWB, **Figure 1**:
 - **CR13** - on indicates the presence of +5V.
 - **CR16** - on indicates the presence of +24V interlocked.
 - **CR50** - flashing at about 2 Hz is the software heartbeat.
 - **CR51** - on indicates the presence of +3.3V (generated on the IOT PWB).
2. If any of the above conditions still fail, then install a new IOT PWB, **PL 1.10 Item 2**.

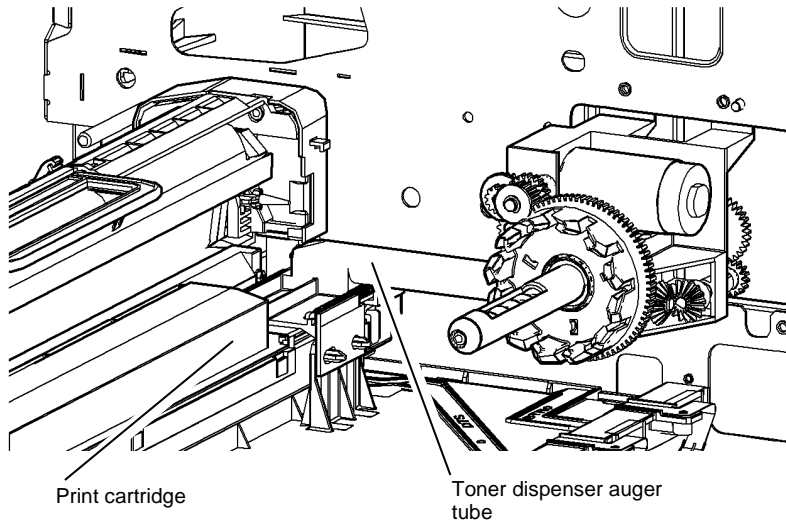
X-1-1230-A

Figure 1 Component location

1. The wiring harness at PJ513. Repair the wiring as necessary, [REP 1.2](#). Refer to [WD 9](#).
2. For damage to the print cartridge CRUM connector, [PL 60.35 Item 18](#). If necessary, install a new LED print head module, [PL 60.35 Item 1](#).
3. Check that the print cartridge fan is working, refer to the [OF6 Air Systems RAP](#).
4. For damage to the CRUM plug on the print cartridge, [PL 90.17 Item 9](#). If necessary, install a new print cartridge, [PL 90.17 Item 9](#).
5. If the fault persists, go to the [OF10 Intermittent Failure RAP](#) and perform the Print Cartridge Checkout.

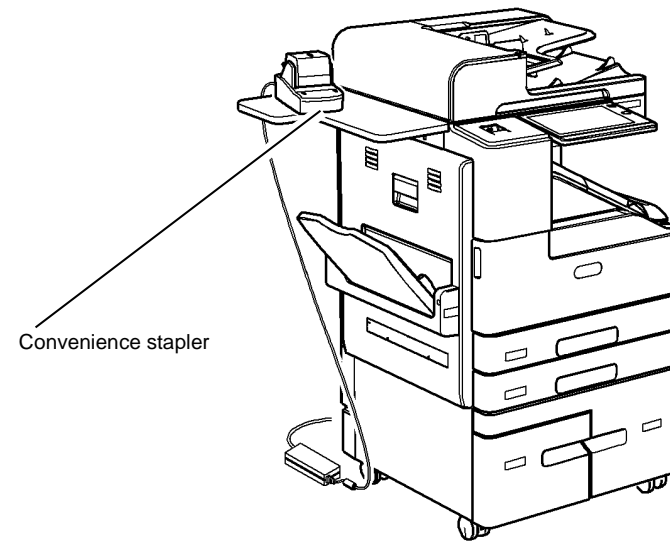
X-1-1078-A

Convenience stapler

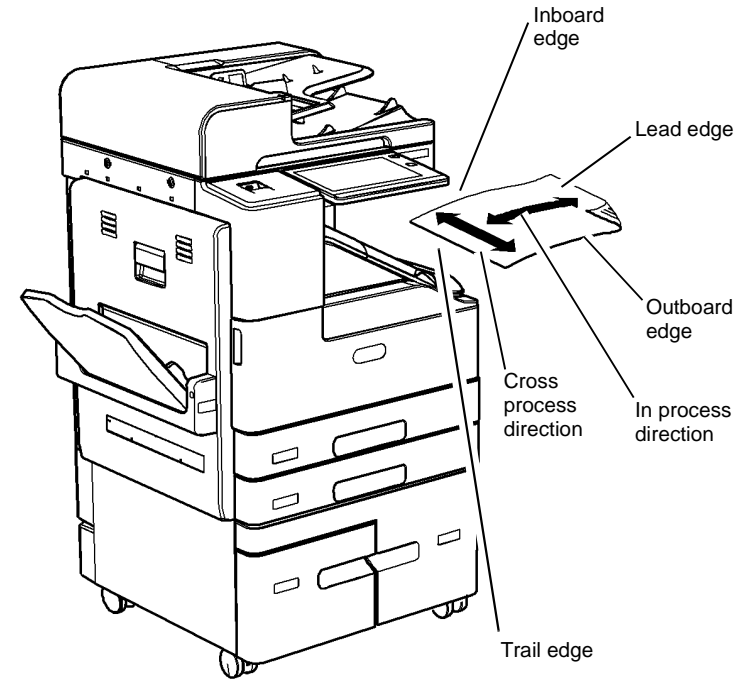
X-1-1229-A

Figure 1 Print/copy definitions

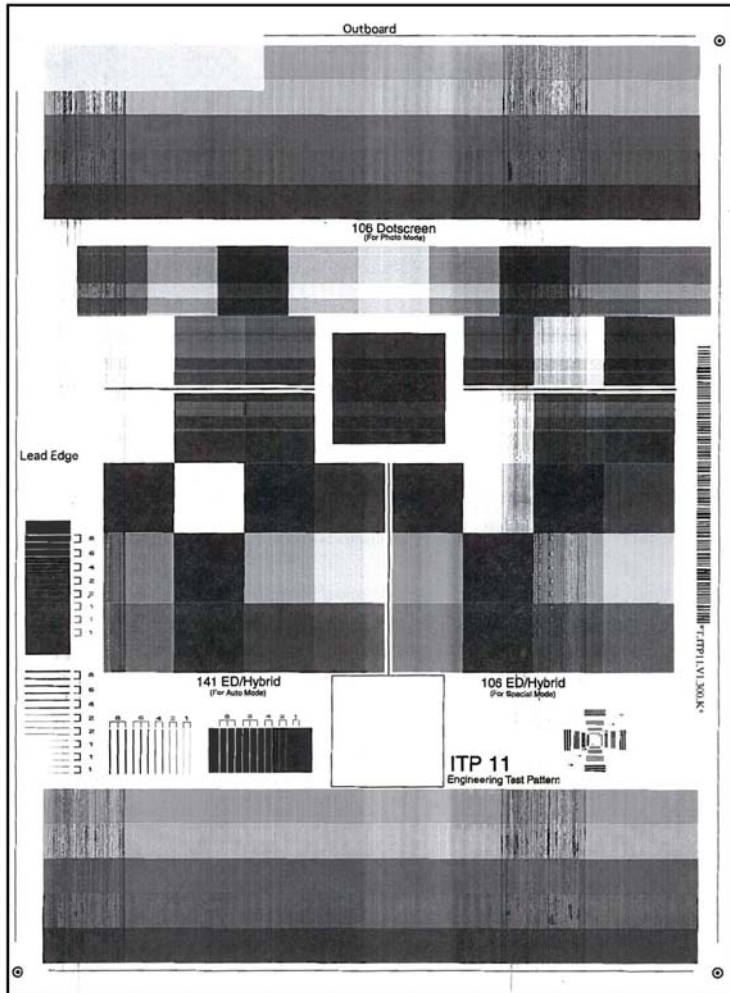
Figure 3 IQ defect sample

The defect shown in Figure 3 is a result of electrostatic discharge (ESD) affecting the LED print head, caused by a loss of grounding.

- If the scrambled image resembles [Figure 3](#), check for grounding problems at the LED print head.
- Check for high voltage arcing. Refer to the [391A HVPS RAP](#).
- Check the connections on the LED print head module to SBC PWB ribbon cable, PJ851 on the SBC PWB, [PL 3.22 Item 3](#) and PJ511 on the LED print head assembly, [PL 60.35 Item 15](#). Refer to [WD 2](#).
- Go to [OF10](#) Intermittent Failure RAP and perform the [Electrostatic Discharge Checkout](#).
- Go to the [IQ3](#) Xerographic RAP and perform the [LED Print Head Checkout](#).

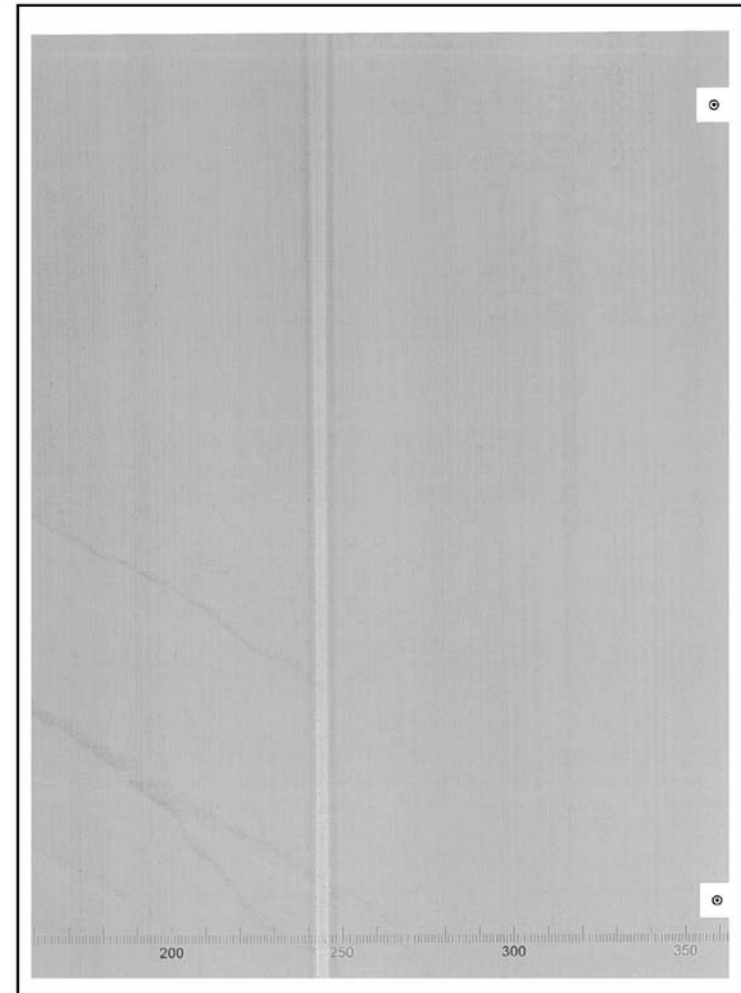
Figure 4 IQ defect sample

The defect shown in Figure 4 is the result of a light shocked photoreceptor caused by the LED print head being energized while the photoreceptor is stationary.

If the band resembles [Figure 4](#), the bands may have been caused by the LED print head being energized while the photoreceptor was stationary. Perform the procedures that follow:

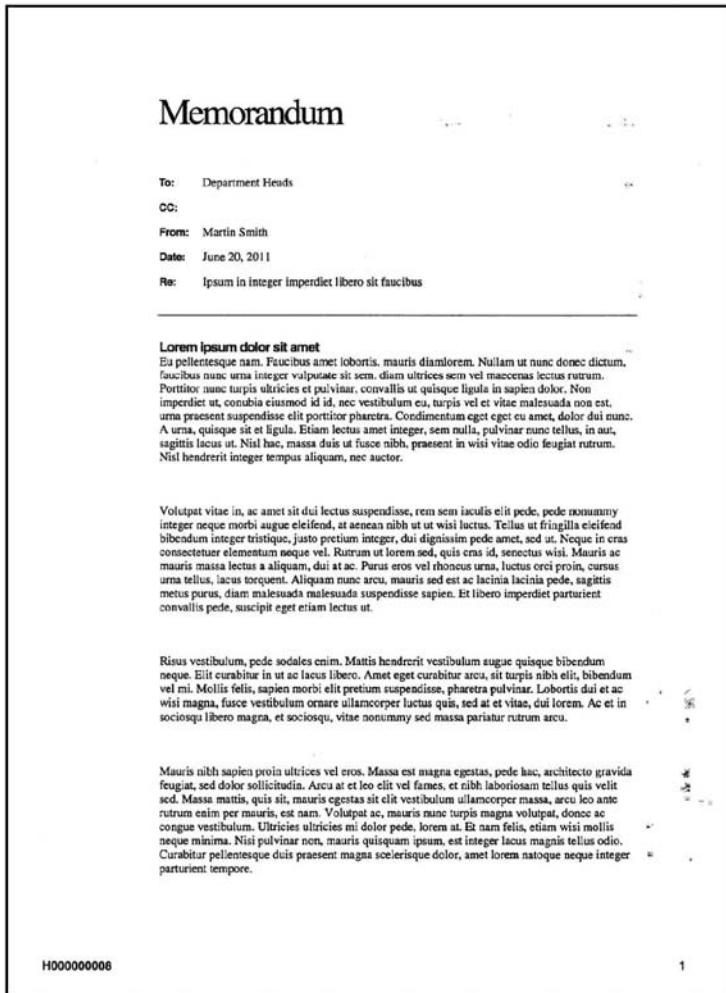
Figure 5 IQ defect sample

The defect shown in Figure 5 is the result of contamination on the fuser guide. This can be seen as image disturbance and contamination deposits towards the trail edge from the image areas of the page.

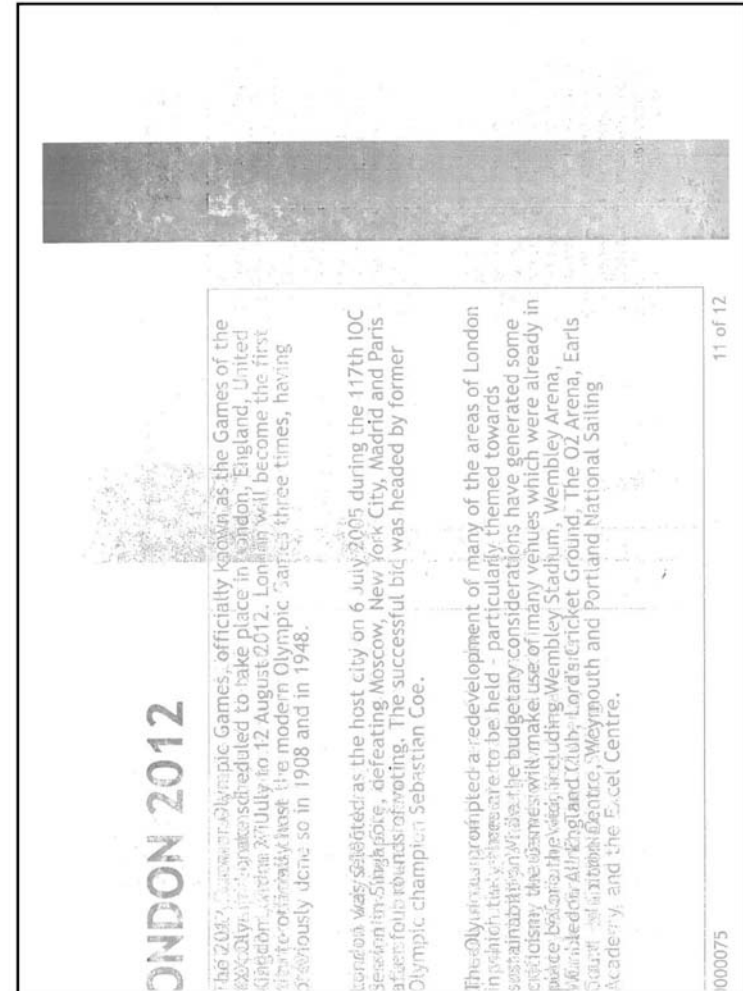
Figure 6 IQ defect sample

The defect shown in Figure 6 is a toner image that adheres to the fuser roll or pressure roll and transfers to another area of the print. The repeat interval for a fuser roll defect or a pressure roll defect is 94.3mm (3.71 inches).

Offsetting. A toner image that adheres to the fuser roll or pressure roll and transfers to another area of the print. The repeat interval for a fuser roll defect or a pressure roll defect is 94.3mm (3.71 inches). Refer to [Figure 6](#).

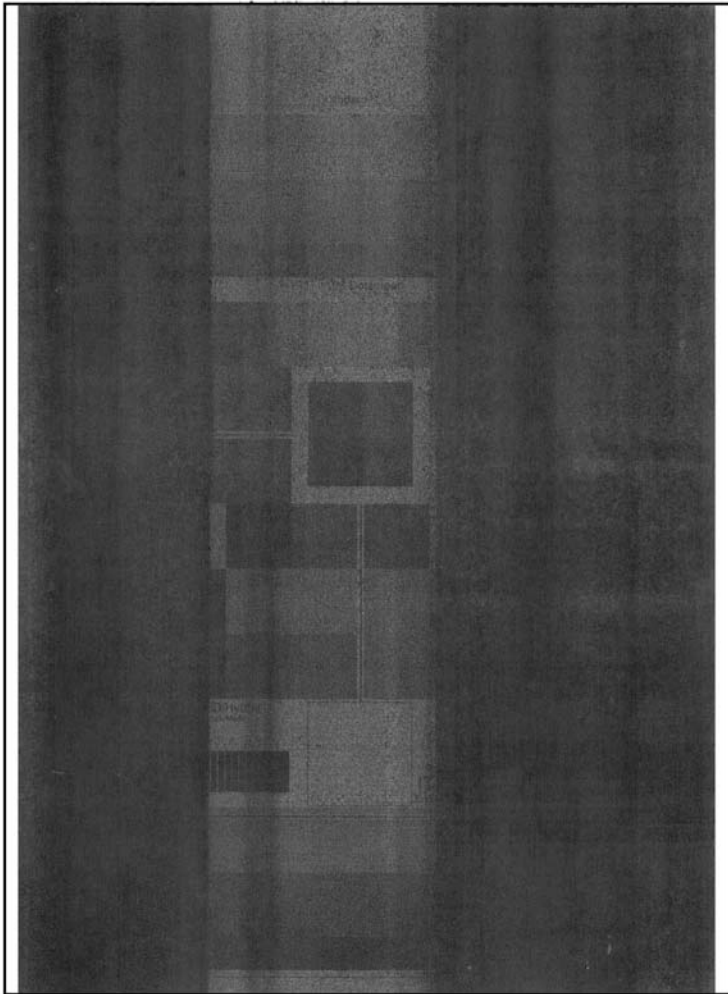
Figure 7 IQ defect sample

The defect shown in [Figure 7](#) is a result of an intermittent loss of bias charge roll voltage.

If the band resembles [Figure 7](#) or [Figure 13](#), the bands may have been caused by an intermittent loss of bias charge roll voltage. Perform the [391A](#) HVPS RAP.

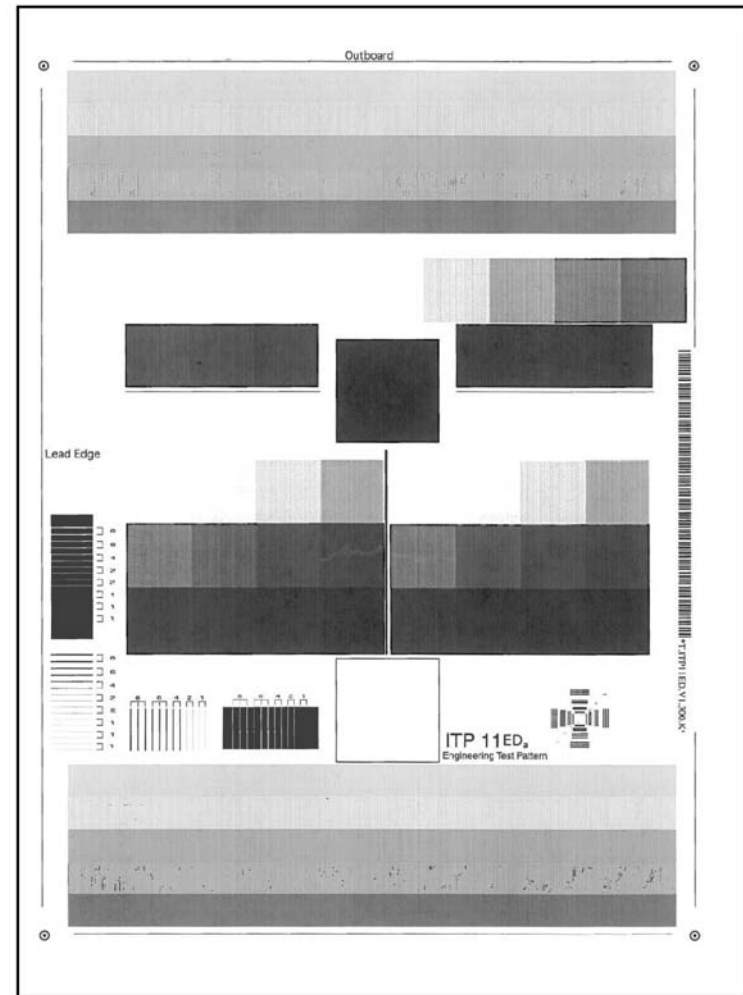
Figure 10 IQ defect sample

The defect shown in [Figure 10](#) is the result of the distance between the LED print head and the photoreceptor being wrong, giving poor focus.

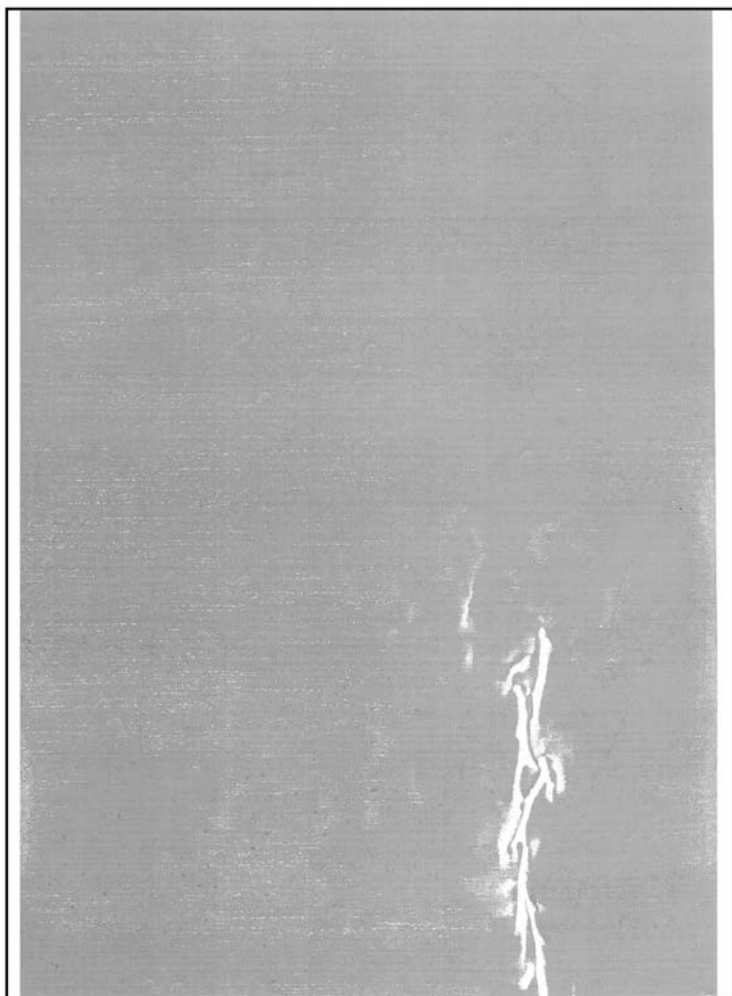
Figure 11 IQ defect sample

The defect shown in [Figure 11](#) is the result of wrinkled paper before transfer, resulting in image loss.

- If the deletions are small and align with the stripper fingers in the fuser module, clean the stripper fingers. If necessary install a new fuser module, **PL 10.8 Item 1**.
- If the deletions resemble those shown in **Figure 11**, go to **IQS 6 Copy / Print Defects** and perform the Paper Wrinkle corrective actions.
- Perform the **IQ3 Xerographic RAP**.

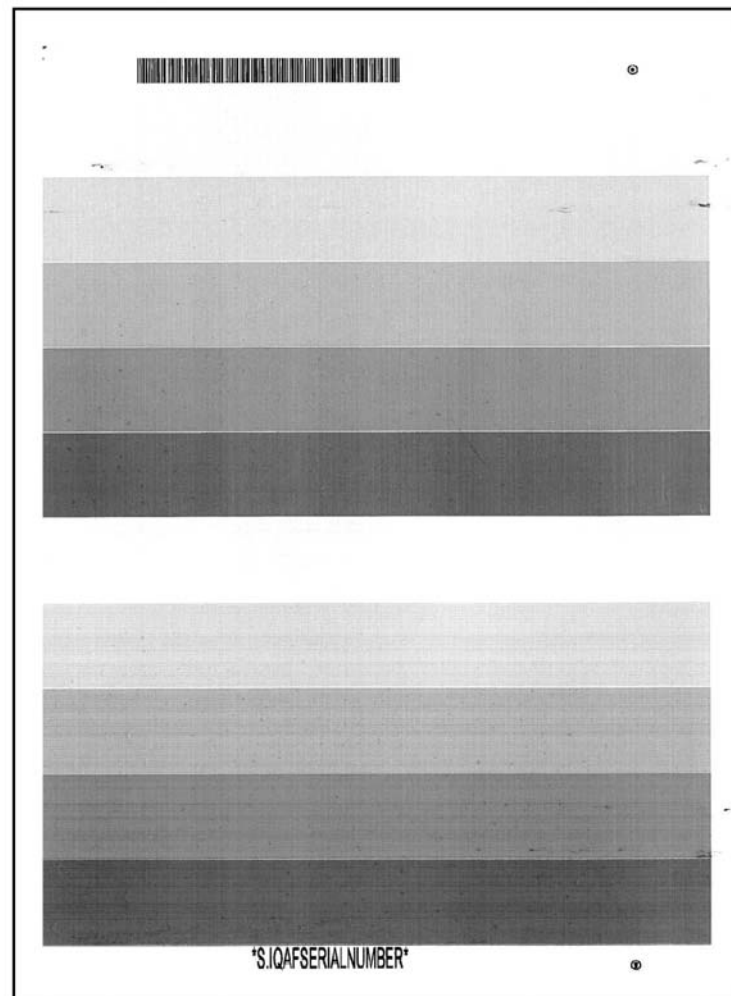
Figure 12 IQ defect sample

The defect shown in [Figure 12](#) is the result of contamination from the print cartridge. This can be seen as random contamination deposits over the entire area of the page.

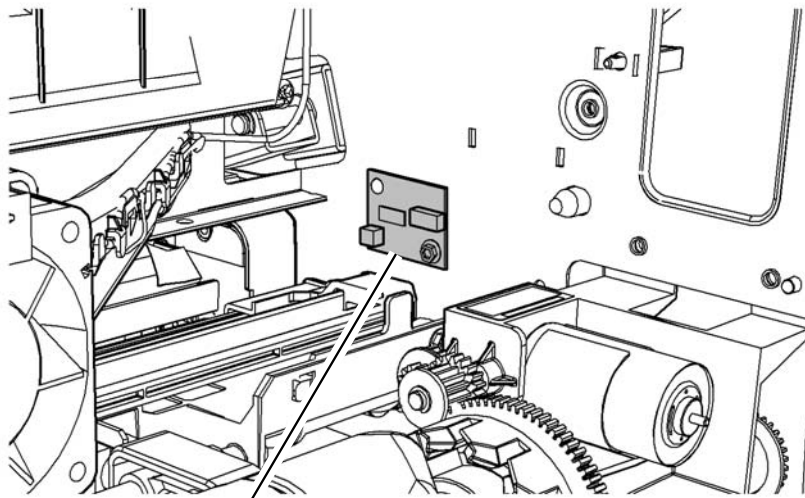
Figure 3 Component location

Humidity sensor (part of the environmental sensors PWB).

The inner machine cover and either the centre output tray or horizontal transport have been removed in this view.

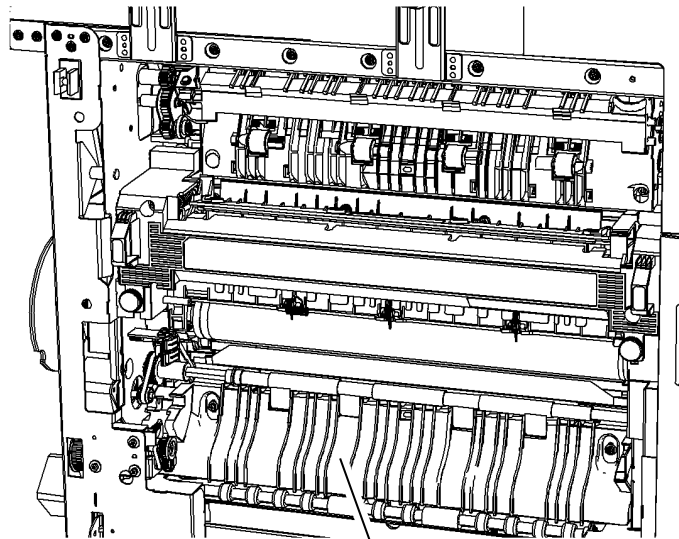
Figure 3 Registration transport

Registration transport housing

- Check the bypass tray baffle, [PL 70.35](#) Item 15 for contamination, wear or damage
- Check the registration transport housing ribs for wear, damage and contamination, [Figure 3](#). If necessary clean the housing or install a new registration transport housing, [PL 80.17](#) Item 1.

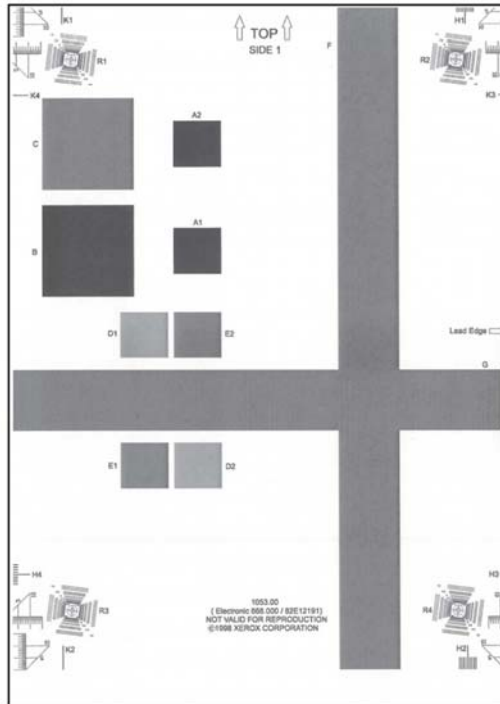
Figure 1 Print skew measurement (simplex)

Lead edge corner scales.

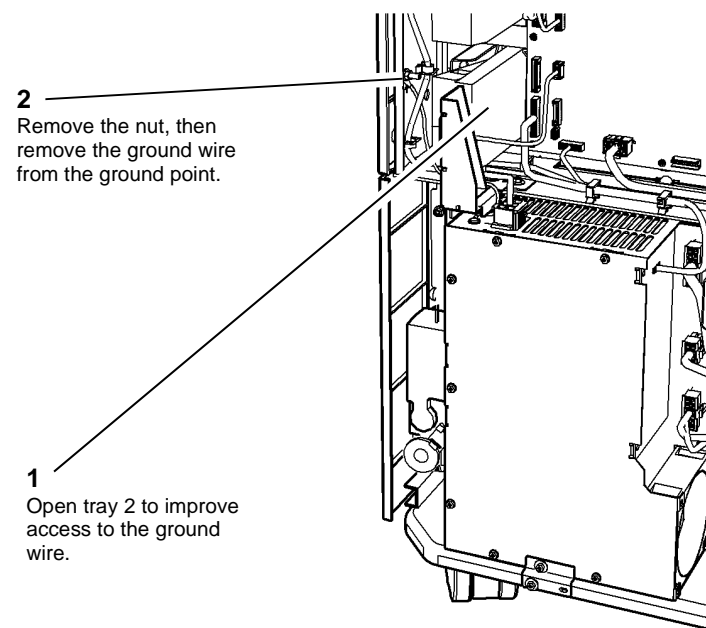
Figure 2 Main frame ground point

2
Remove the nut, then remove the ground wire from the ground point.

1
Open tray 2 to improve access to the ground wire.

1. Switch off the machine, [GP 14](#). Disconnect the power cord.
2. Disconnect the power cord to the output device if fitted.
3. Remove the rear cover, [REP 28.2](#).
4. Remove the lower rear cover, [PL 70.26 Item 1](#).
5. Disconnect the ground wire from the main frame ground point, [Figure 2](#).

1. The replacement is the reverse of the removal procedure.
2. Ensure that the nut on the main frame ground point is tightened to secure the ground terminal. Refer to [Figure 2](#).
3. Using a digital multimeter set to a resistance range, verify that there is continuity between the ground pin on PJ651 and the frame ground point of less than 10 ohms, [Figure 5](#).

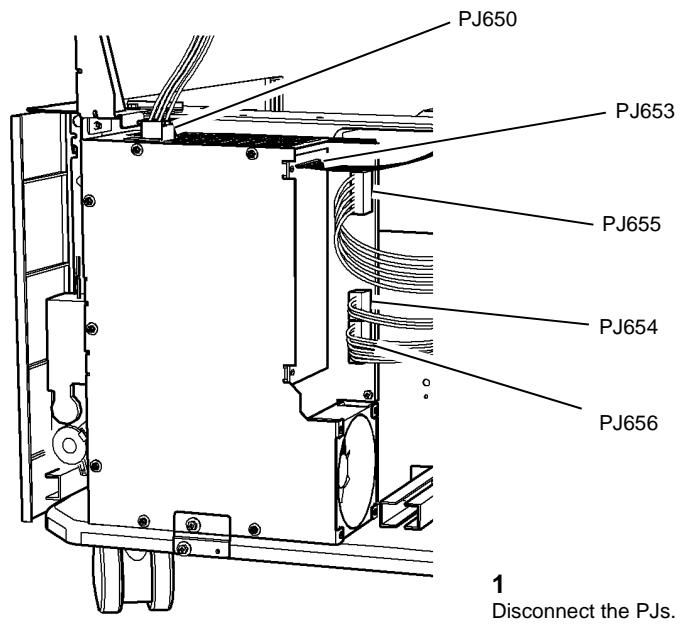
Figure 3 Wiring disconnection

6. Disconnect the wiring to the LVPS, [Figure 3](#).

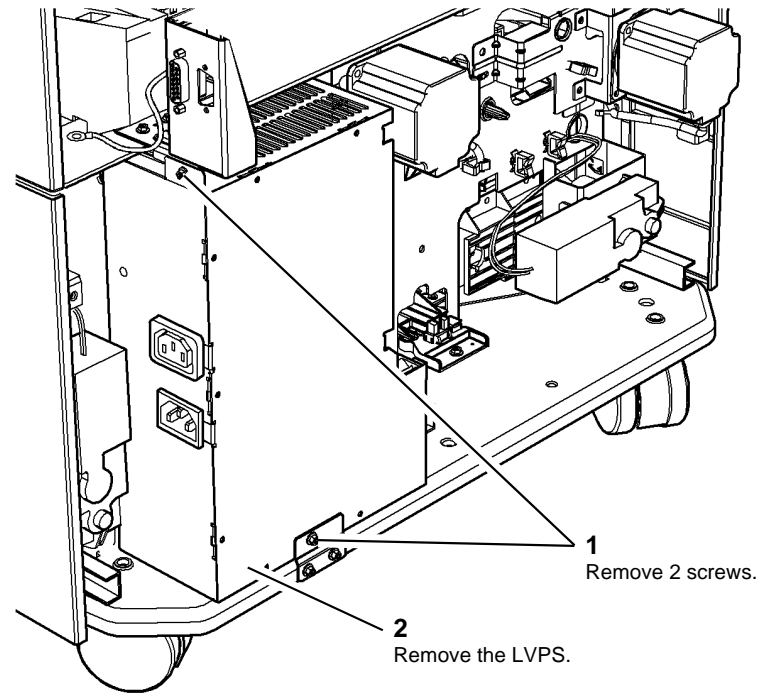
Figure 4 LVPS module removal

7. Remove the LVPS module, [Figure 4](#).

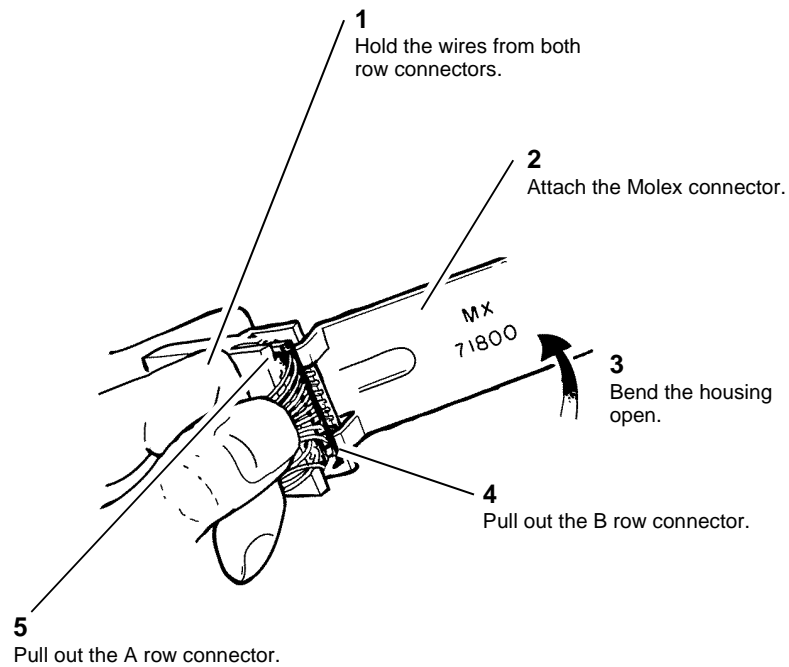
Figure 1 Disassembling the connector

1. If the damaged connector is in the centre of a double row housing beneath the latching clip, the latching prong will not be accessible to release the connector from the housing. Therefore it will be necessary to disassemble the housing as shown in Figure 1.

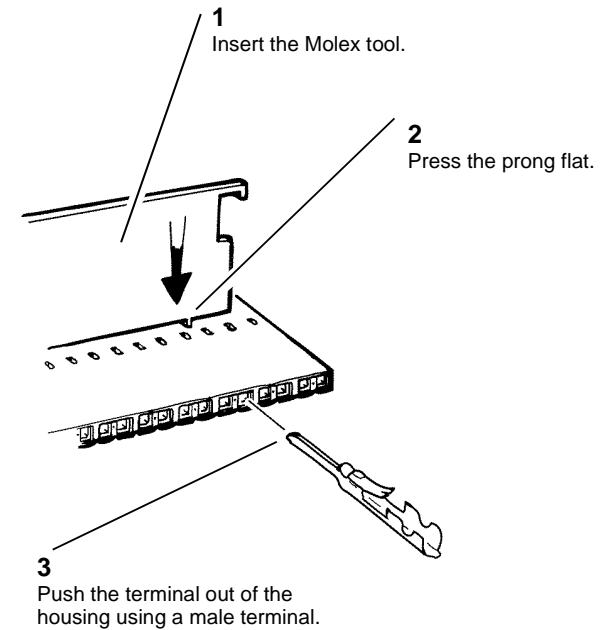
Figure 2 Removing the terminal

2. Remove the terminal from the connector housing using the Molex extractor tool, Figure 2.

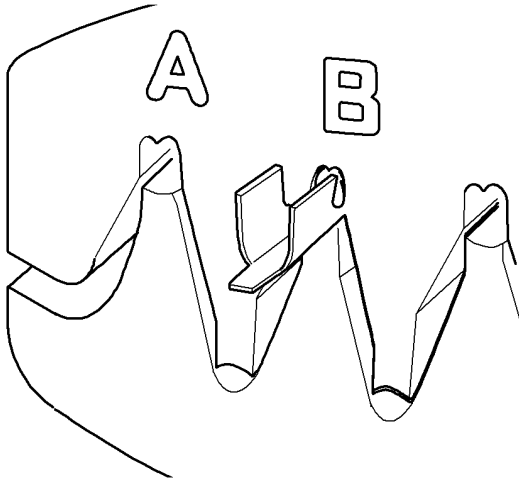
Figure 3 Crimping the terminal

1. Select the correct replacement terminal, and identify the appropriate crimp positions for the terminal.
2. Insert a male or female terminal into the appropriate position of the crimp tool, then close the tool just enough to hold the terminal, [Figure 3](#).

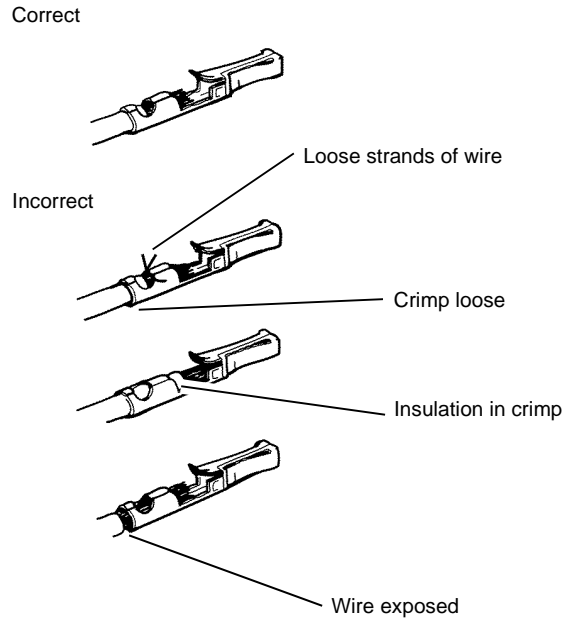
Figure 5 Inspecting the finished crimp

5. Check that the crimp is correctly made, [Figure 5](#).

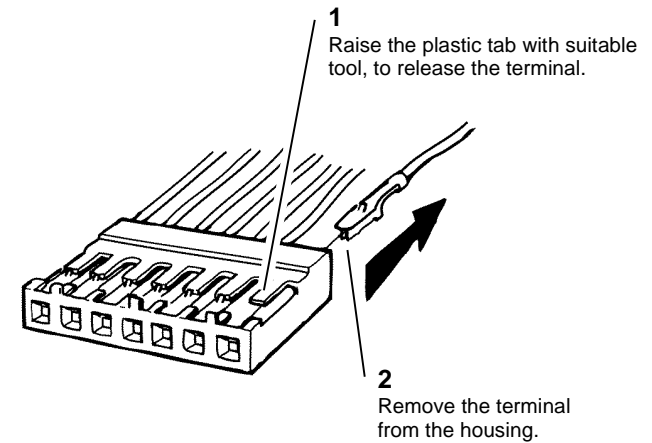
Figure 1 Remove the terminal

1. Remove the damaged terminal from the housing, [Figure 1](#).

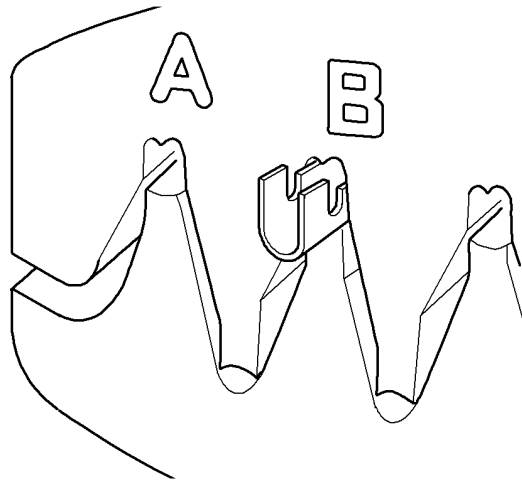
Figure 2 Crimping the terminal

2. Insert the terminal into the appropriate position of the crimp tool and close the tool just enough to hold the terminal, [Figure 2](#).

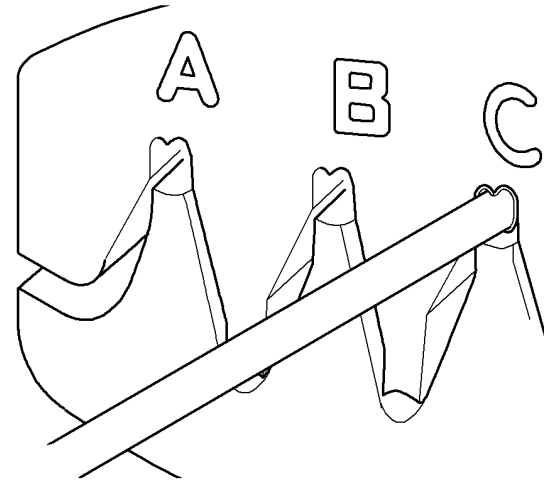
Figure 3 Crimping the insulation grip

4. Insert the crimped terminal into the appropriate position of the crimp tool, then close the crimp tool to firmly fasten the insulation of the wire in the cable grip of the terminal, [Figure 3](#).

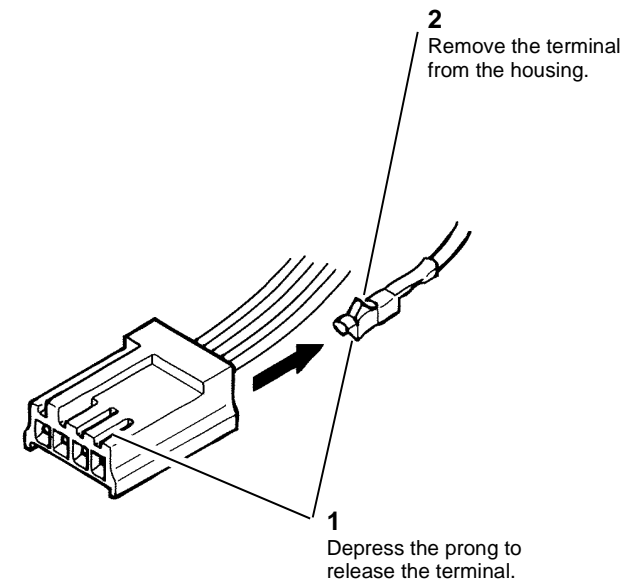
Figure 1 Terminal removal; male housing

NOTE: The male housings contain socket terminals, and the female housings contain pin terminals.

1. Use the extractor tool, to release the terminal from the housing. Refer to [Figure 1](#) to identify the male housing and terminal type. Refer to [Figure 2](#) to identify the female housing and the terminal type.

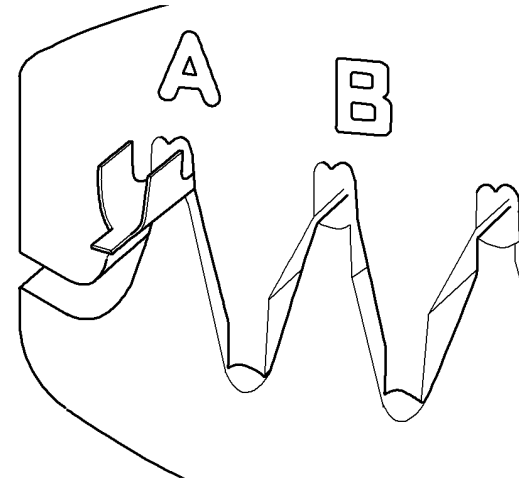
Figure 3 Crimping the terminal

1. Select the correct replacement terminal and identify the appropriate crimp positions for the terminal.
2. Insert the terminal into the appropriate position of the crimp tool and close the tool enough to hold the terminal, [Figure 3](#).

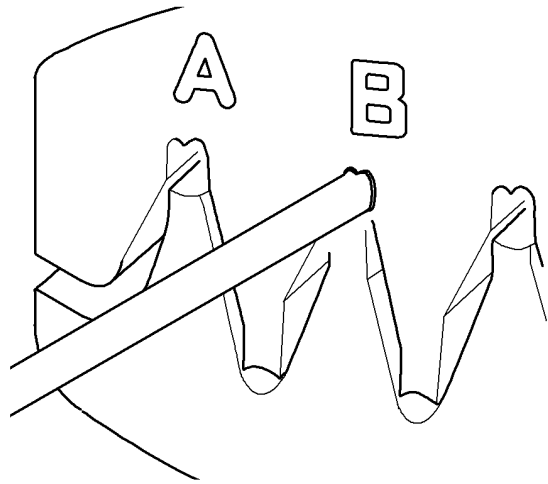
Figure 4 Crimping the insulated grip

4. Insert the crimped terminal into the appropriate position of the crimp tool and close the crimp tool to firmly fasten the insulation of the wire in the cable grip of the terminal, [Figure 4](#).

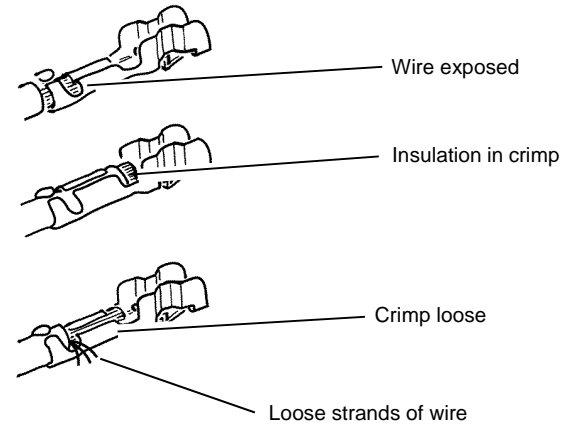
Figure 5 Inspect the finished crimp

Incorrect

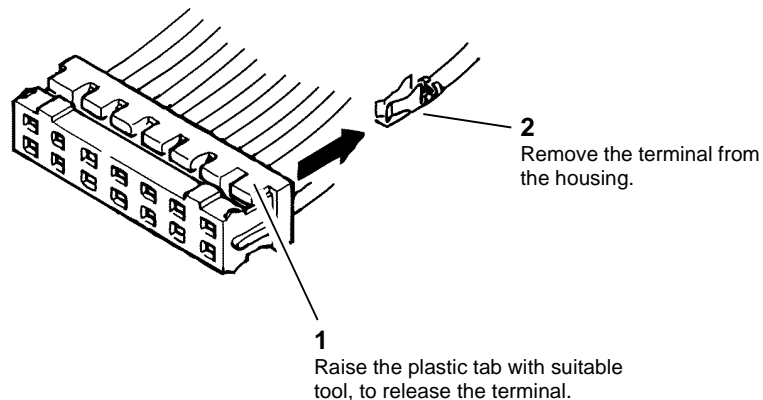
Figure 1 Terminal removed

NOTE: The male housing contains female terminals that cannot be crimped in the field; if a terminal is damaged, install a new terminal with flying lead.

1. Remove the damaged terminal from the connector housing, **Figure 1**.

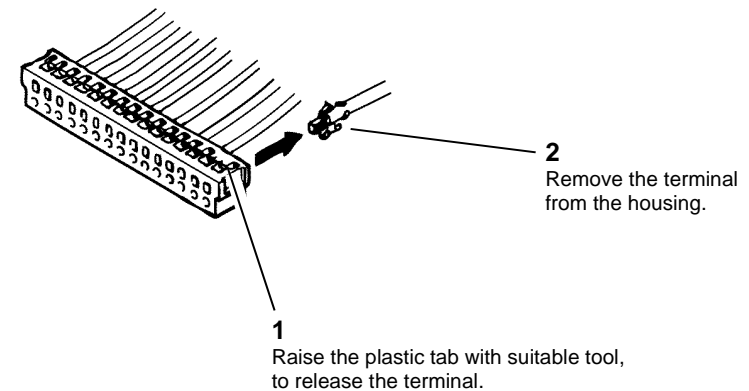
Figure 1 Terminal removal

1. Identify the terminal type. Go to step 2 for a housing containing crimp terminals, or go to step 4 for a housing containing insulation displacement (IDC) terminals.
2. Remove the damaged crimp terminal from the connector housing, **Figure 1**.

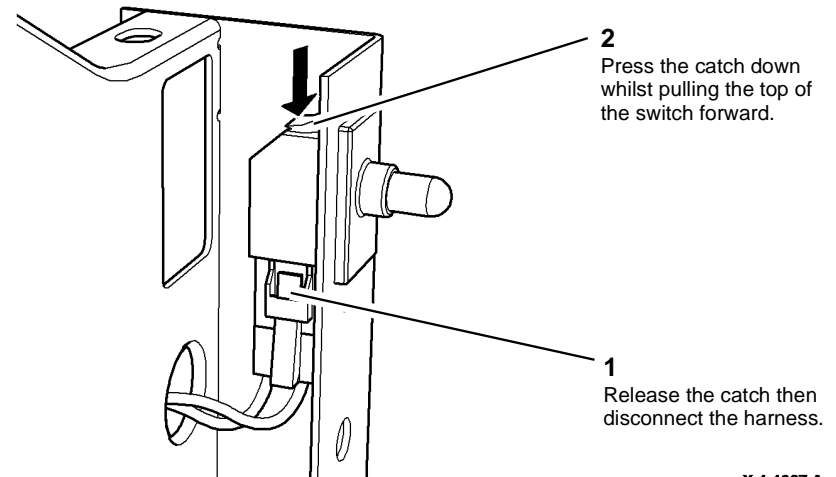
Figure 1 Switch release

1. Remove the latch, [PL 60.35 Item 2](#) (1 screw).
2. Remove the inner front cover, [PL 28.10 Item 10](#) (3 screws).
3. Release the front door interlock switch, [Figure 1](#).

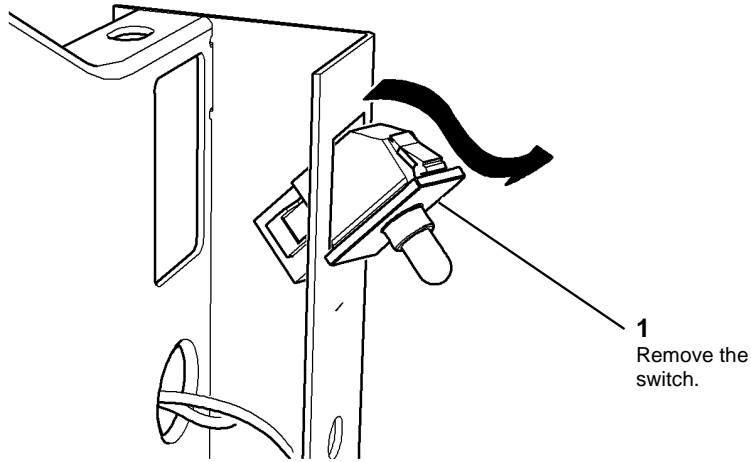
Figure 2 Switch removal

- Remove the front door interlock switch, [Figure 2](#).

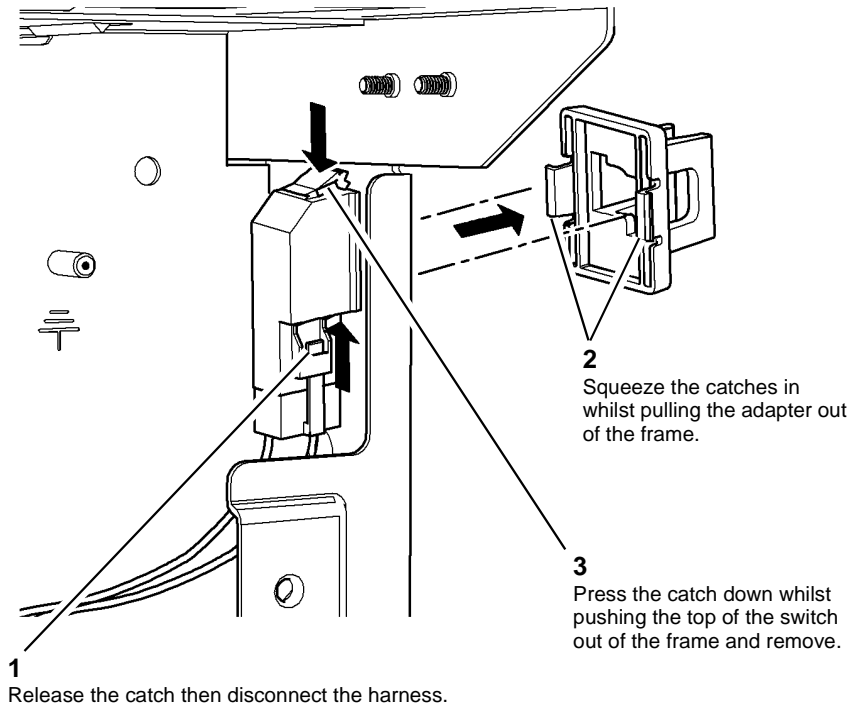
Figure 1 Switch removal

NOTE: It may be necessary to cut some tie-wraps on the switch harness to provide enough slack to remove the switch.

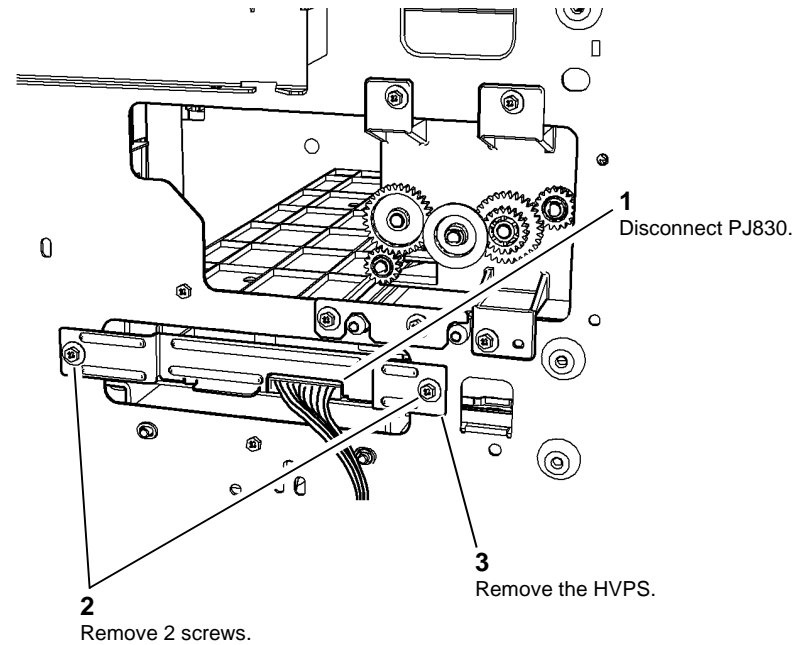
Figure 2 HVPS removal

4. Remove the HVPS, [Figure 2](#).

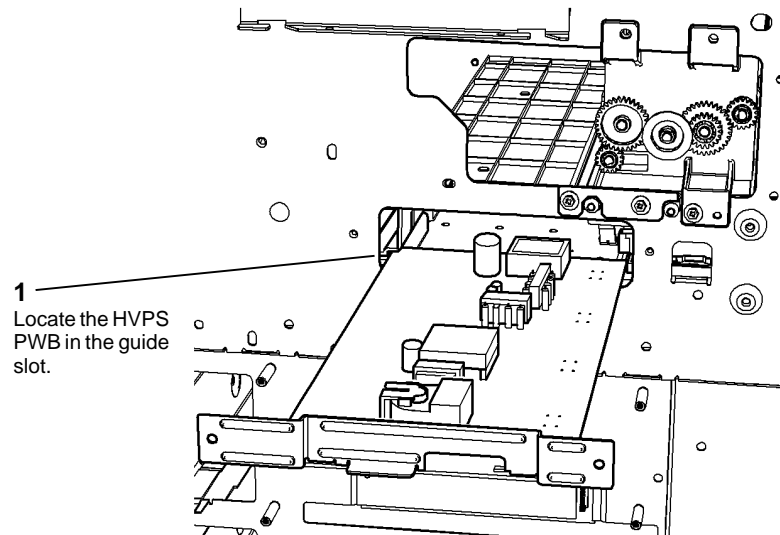
Figure 3 HVPS replacement

1. The replacement is the reverse of the removal procedure.
2. Align the left side of the HVPS PWB into the guide slot then push the HVPS into the machine, [Figure 3](#).

- 2
Slide in the HVPS.

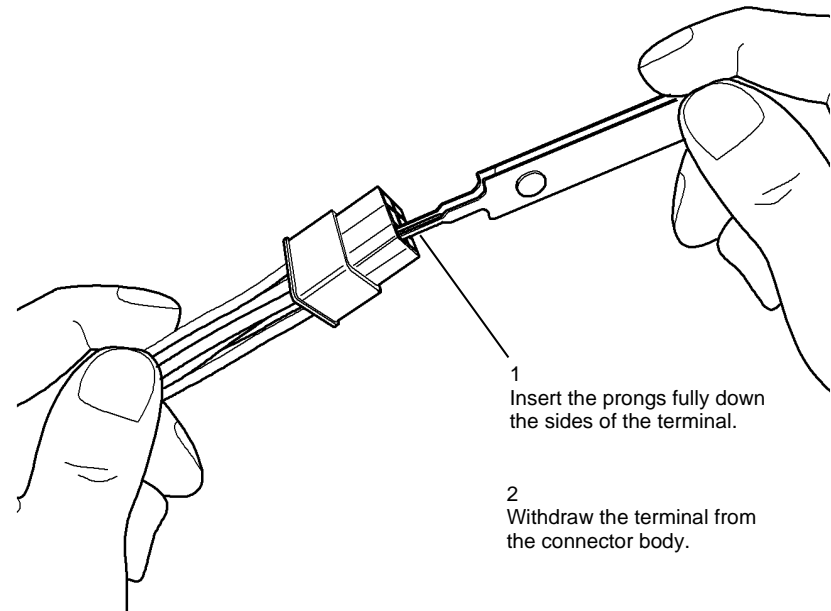
Figure 1 Removing the terminal

1. Remove the terminal from the housing, using the Molex, Mini-Fit extractor tool, [Figure 1](#).

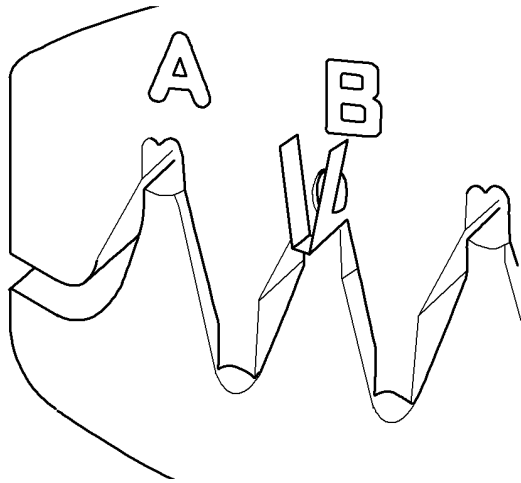
Figure 2 Crimping the terminal

2. Insert the terminal into the appropriate position of the crimp tool and close the tool just enough to hold the terminal, [Figure 2](#).
