708P91368
September 2017

Xerox® AltaLink® B8090 Family Multifunction Printer Service Manual

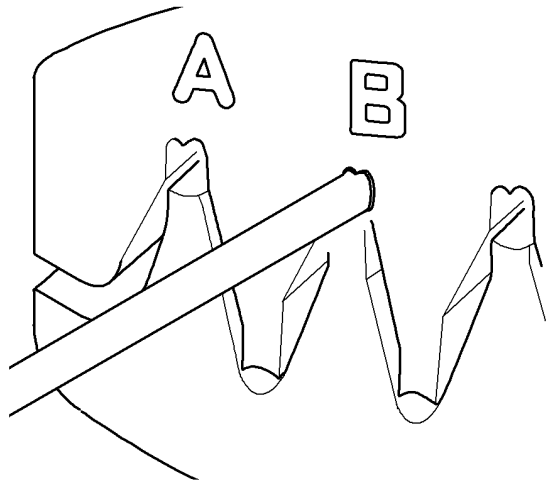
Figure 3 Crimping the insulation grip

3. Insert the wire fully into the terminal so that the stripped portion is within the inner grip of the terminal. Close the crimp tool of the terminal. Close the crimp tool fully to make the crimp.
4. Insert the crimped terminal into the appropriate position of the crimp tool and close the crimp tool to fasten the wire insulation in the outer grip of the terminal, [Figure 3](#).

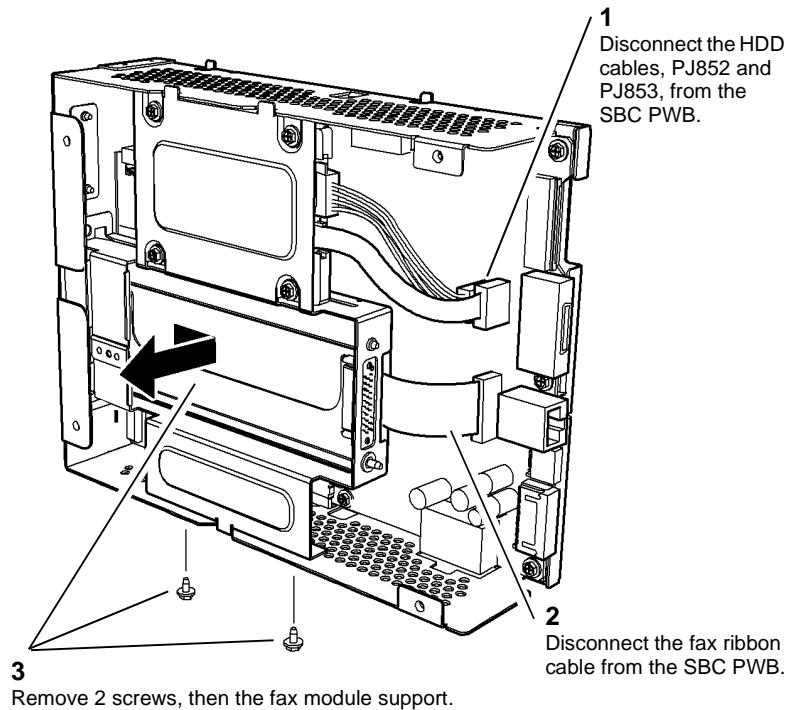
Figure 2 Fax module support removal

4. Remove the fax module support, [Figure 2](#).

NOTE: If a foreign device interface is installed, carefully pull the FDI ribbon cable away from the fax module support before removing the fax module support.

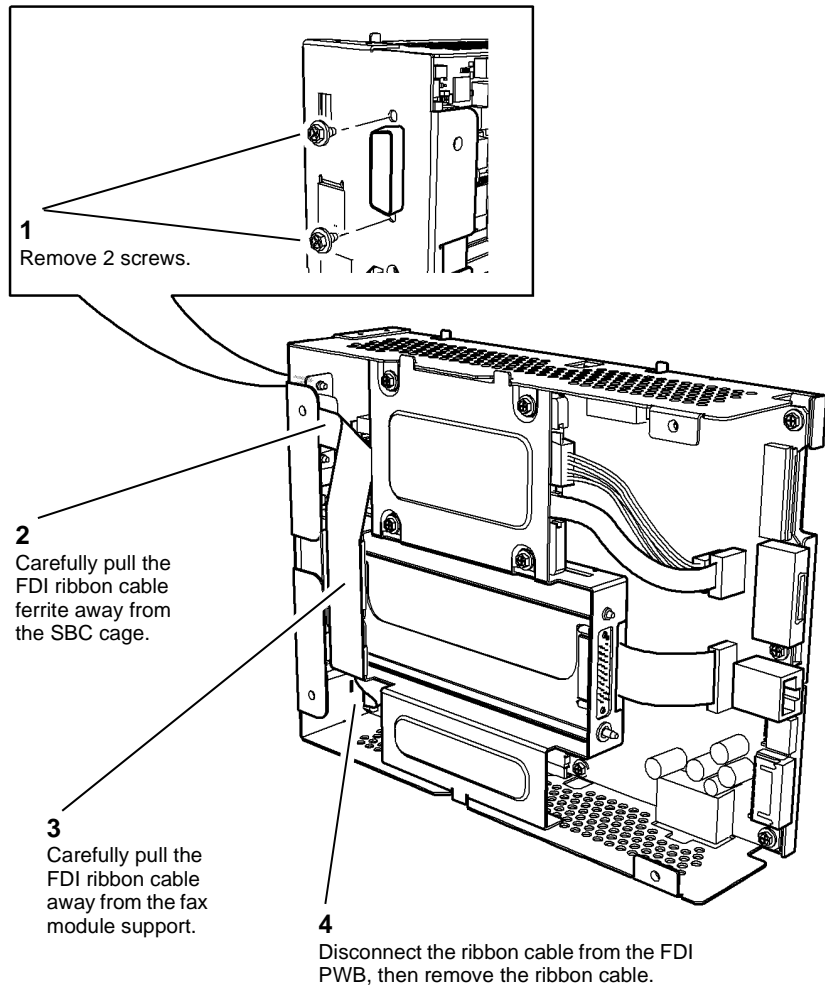
X-1-1225-A

3. Remove the FDI ribbon cable from the SBC cage, [Figure 2](#).

Figure 2 FDI ribbon cable

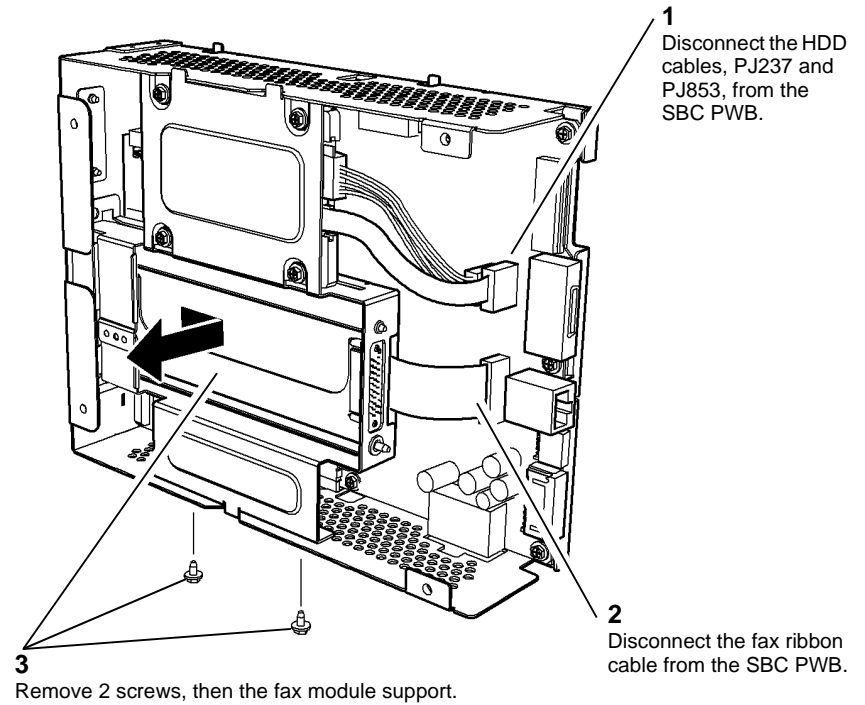
X-1-1226-A

4. Remove the fax module support, [Figure 3](#).

Figure 3 Fax module support removal

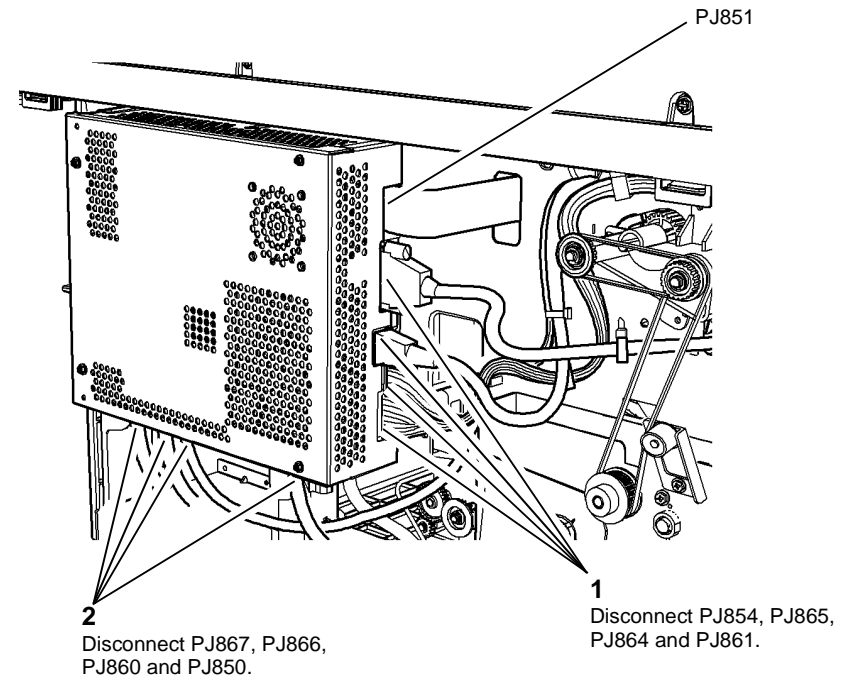
X-1-1291-A

3. Prepare to remove the SBC module, [Figure 2](#).

Figure 2 Preparation

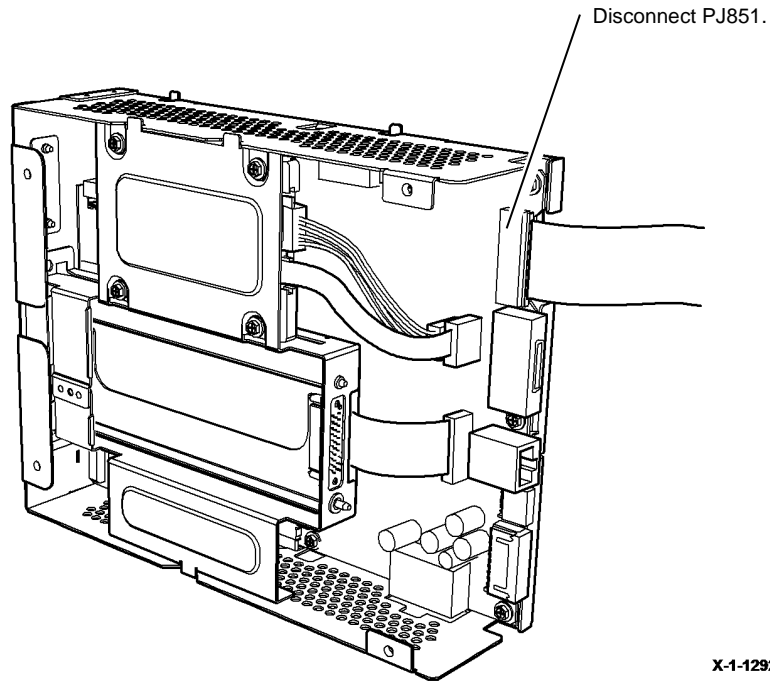
X-1-1292-A

Disconnect PJ851 by carefully releasing the clamp. The cable clamp is very fragile and only needs to be moved slightly to release the ribbon cable.

5. Disconnect PJ851, [Figure 3](#).

Figure 3 Disconnect PJ851

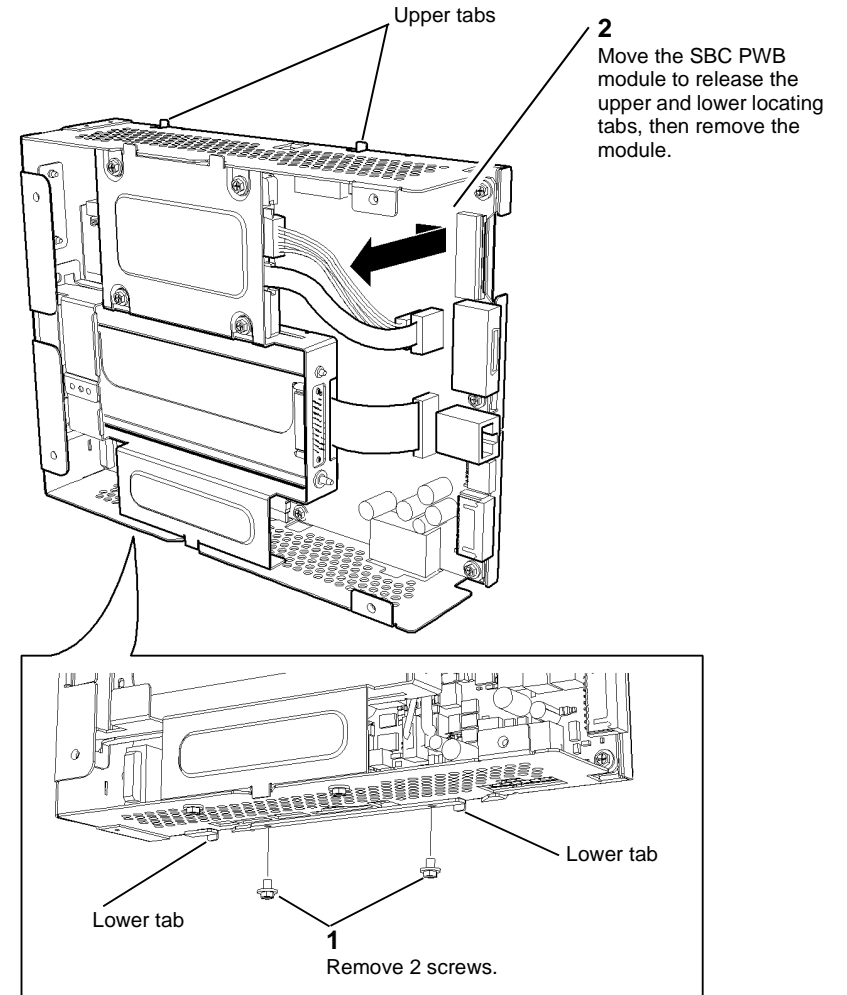
X-1-1293-A

6. Remove the SBC PWB module, [Figure 4](#).

Figure 4 Removal

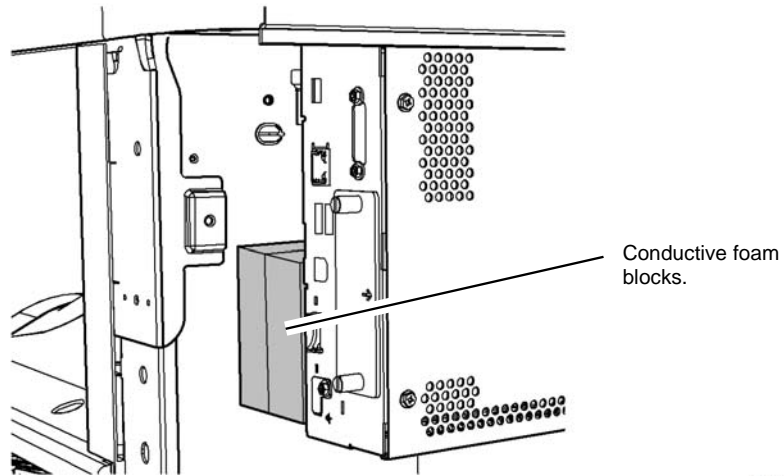
X-1-2028-A

1. On 50Hz machines only, when installing the SBC PWB module, ensure that the conductive foam blocks are correctly located between the machine frame and the SBC PWB module, [Figure 5](#).

Figure 5 Conductive foam blocks

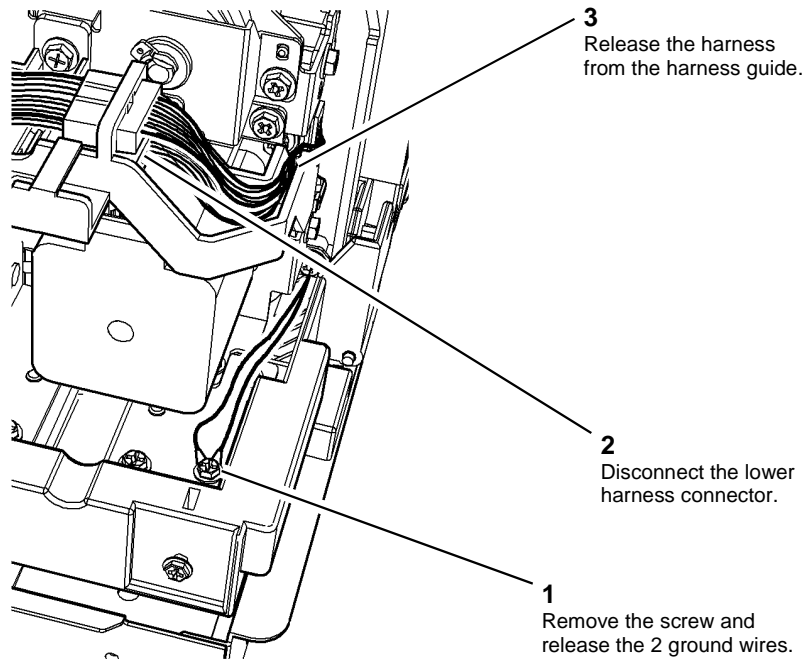
X-1-1787-A

1. Open the SPDH top cover assembly, [PL 5.20 Item 15](#).
2. Remove 5 screws then remove the SPDH rear cover, [PL 5.10 Item 1](#).
3. Prepare to remove the top cover assembly, [Figure 1](#).

Figure 1 Preparation

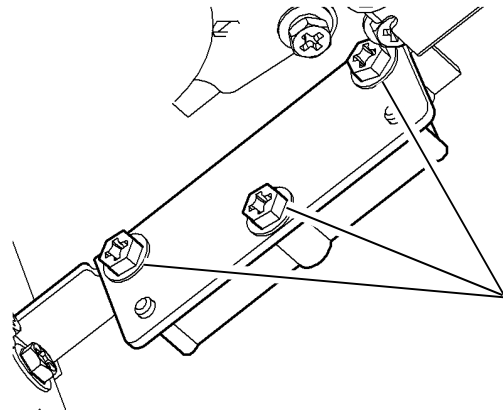
X-1-1789-A

- Remove the top cover assembly, [Figure 3](#).

- Remove 3 screws from the rear hinge, then lower the cover from the hinge.

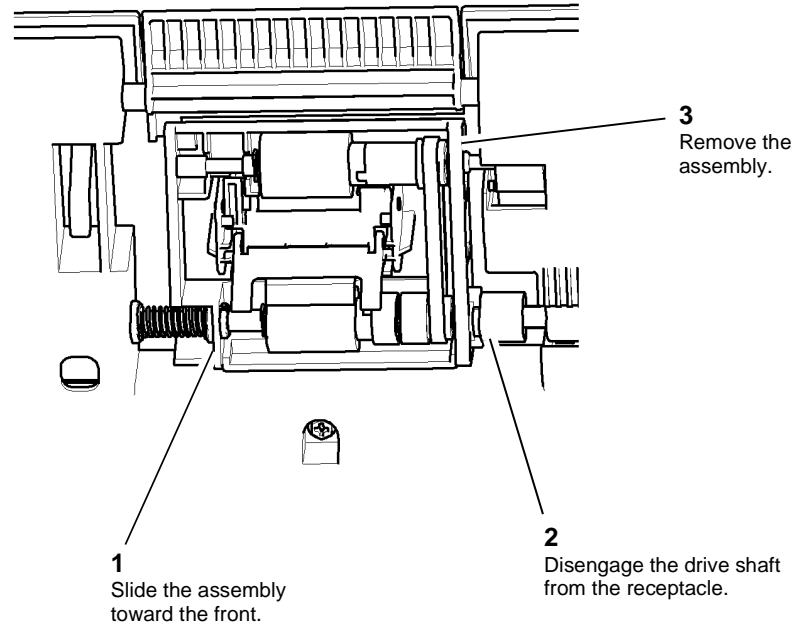
- Open the SPDH top cover assembly, [PL 5.20 Item 14](#).
- Remove the feed and nudger rolls assembly, [Figure 1](#).

- Slide the assembly toward the front.

- Disengage the drive shaft from the receptacle.

Figure 1 Feed and Nudger assembly removal

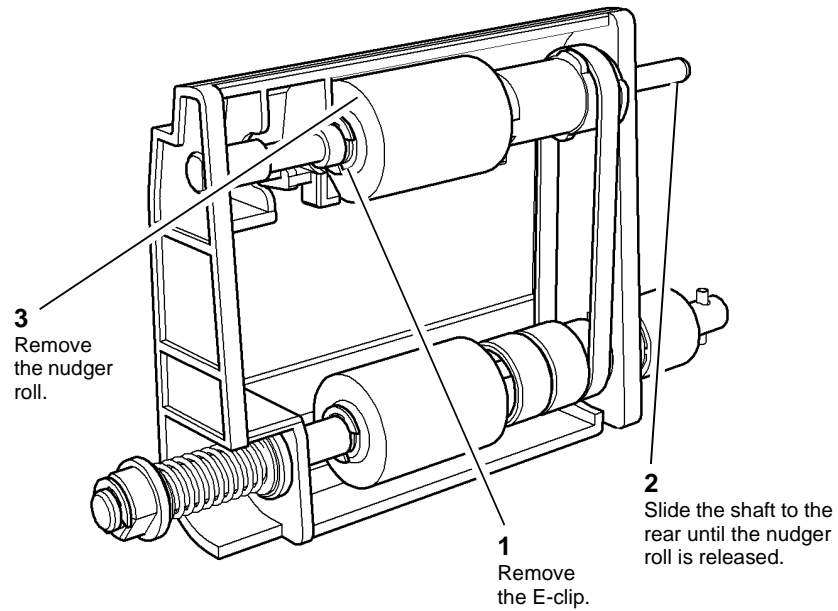
X-11791-A

3. Remove the nudger roll, [Figure 2](#).

Figure 2 Nudger roll removal

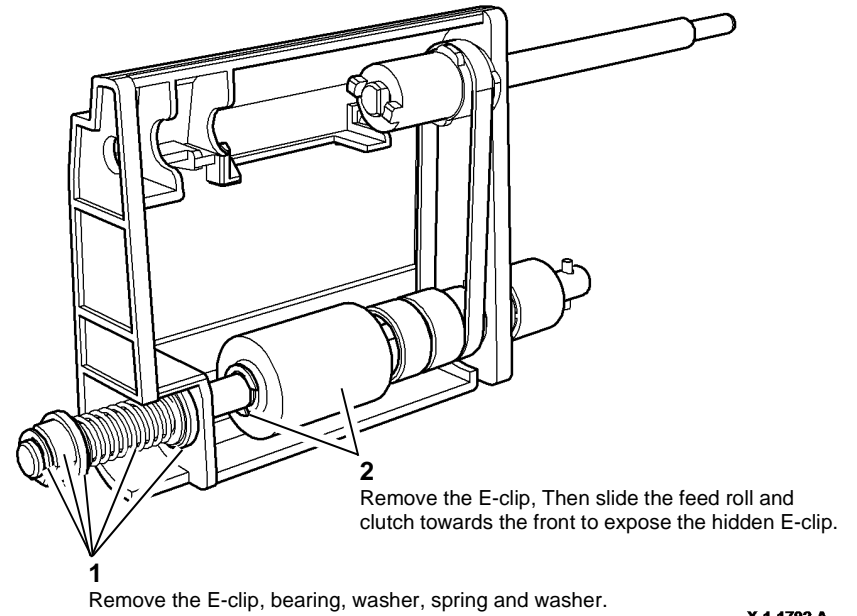
X-1-1792-A

4. Prepare to remove the feed roll, [Figure 3](#).

Figure 3 Preparation

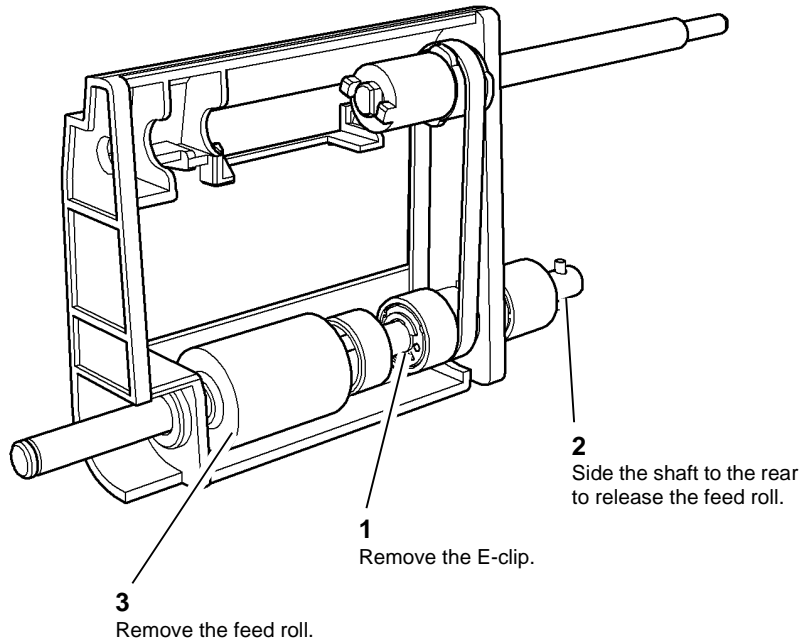
X-1-1793-A

- Remove the feed roll, [Figure 4](#).

Figure 4 Feed roll removal

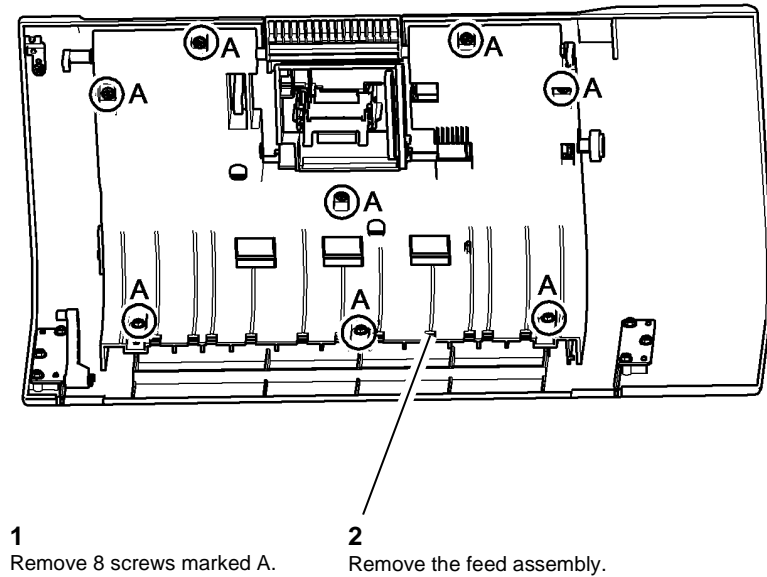
X-1-1794-A

- Remove the feed assembly, [Figure 5](#).

Figure 5 Feed assembly removal

Ensure the harness to the feed assembly is routed around the harness guide to clear the hinge at the rear of the top cover assembly. If the harness is not routed correctly the harness can cause the top cover to jam.

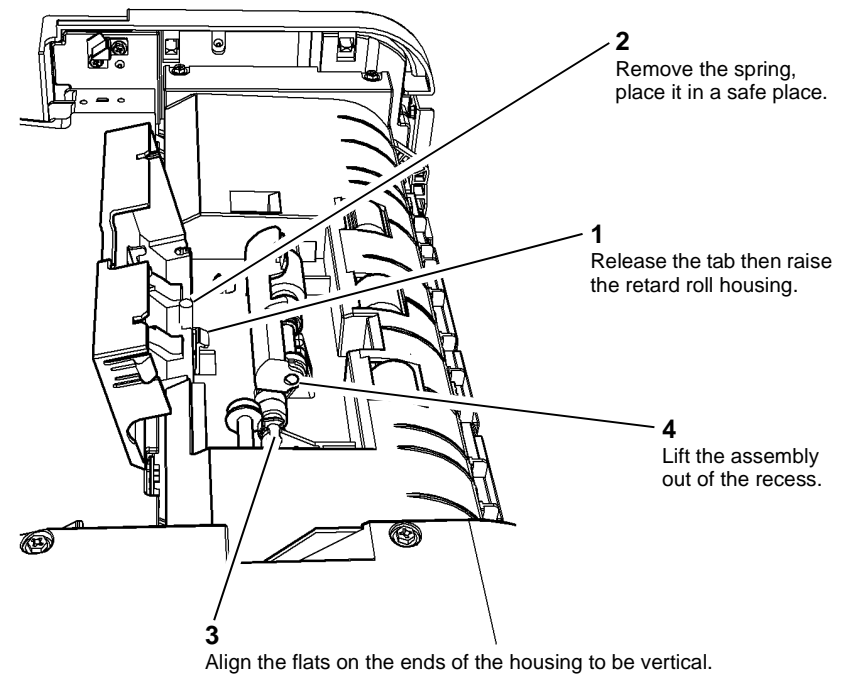
X-1-1795-A

2. Pull open the retard roll cover, [PL 5.25 Item 2](#).
3. Remove the retard roll assembly, [Figure 1](#).

NOTE: The retard roll can be removed without previously removing the retard roll assembly.

Figure 1 Retard roll assembly removal

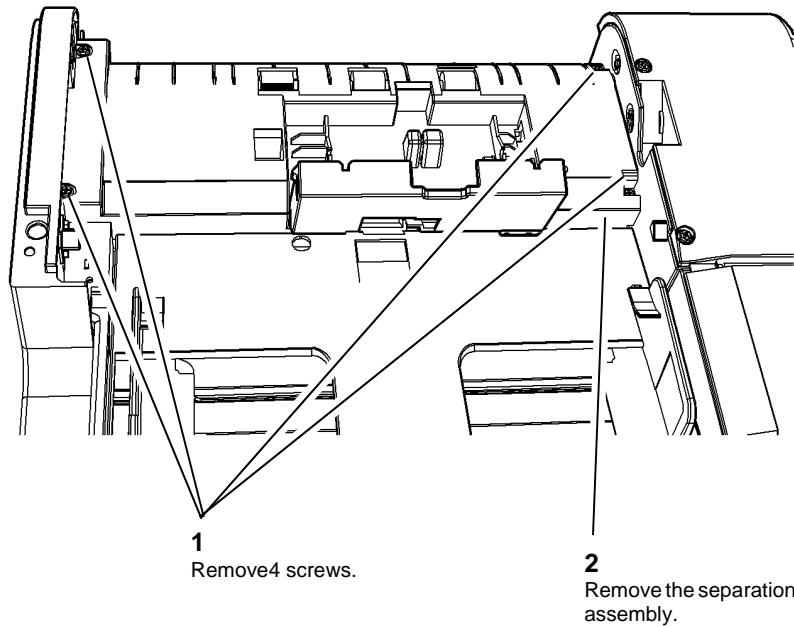
X-1-1796-A

5. Remove the separation assembly, [Figure 2](#).

NOTE: The separation assembly can be removed without previously removing the retard roll assembly.

Figure 2 Separation assembly removal

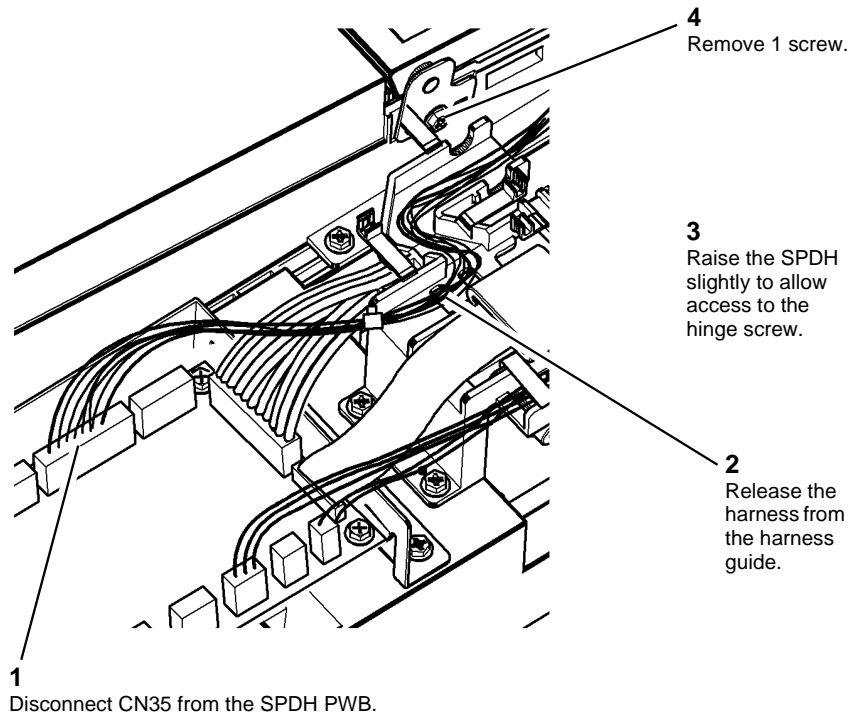
X-1-1797-A

3. Prepare to remove the input tray upper assembly, [Figure 1](#).

Figure 1 Preparation

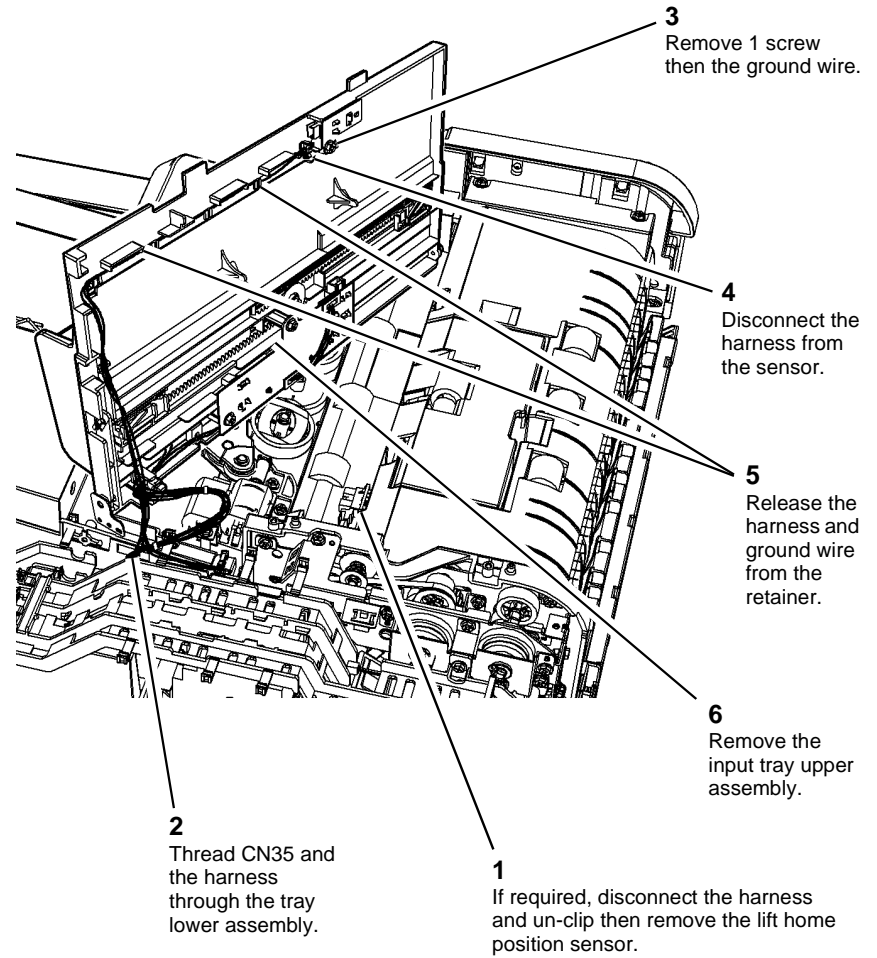
X-1-1798-A

4. Remove the input tray upper assembly, [Figure 2](#).

Figure 2 Upper assembly removal

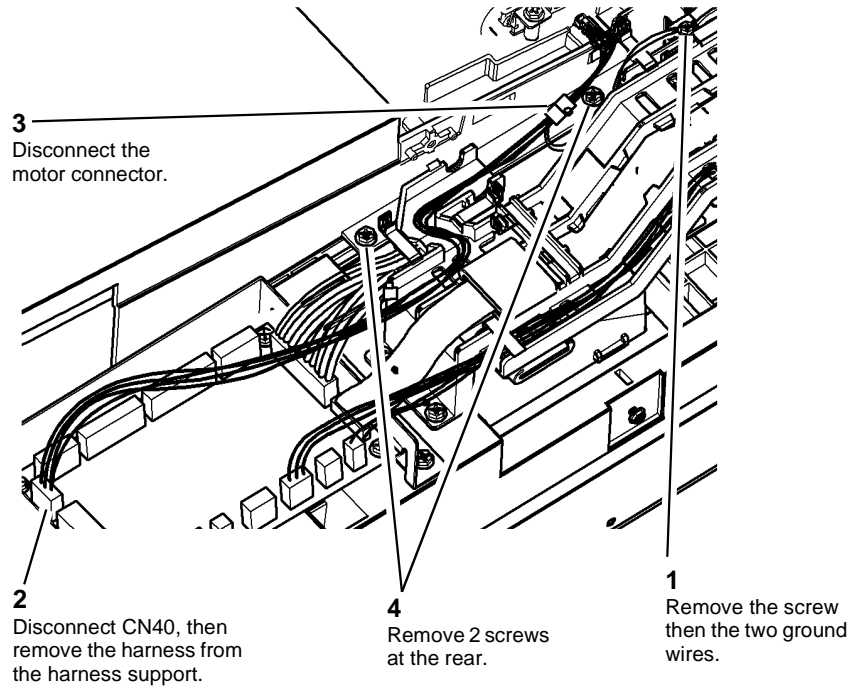
X-1-1799-A

5. Prepare to remove the input tray lower assembly, [Figure 3](#).

Figure 3 Preparation

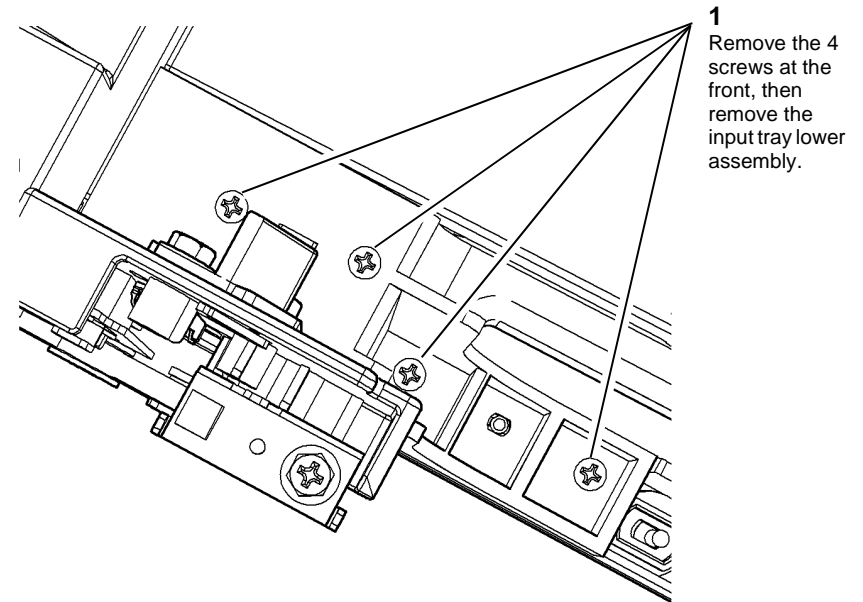
X-1-1800-A

7. Remove the input tray lower assembly, [Figure 4](#).

Figure 4 Input tray lower removal

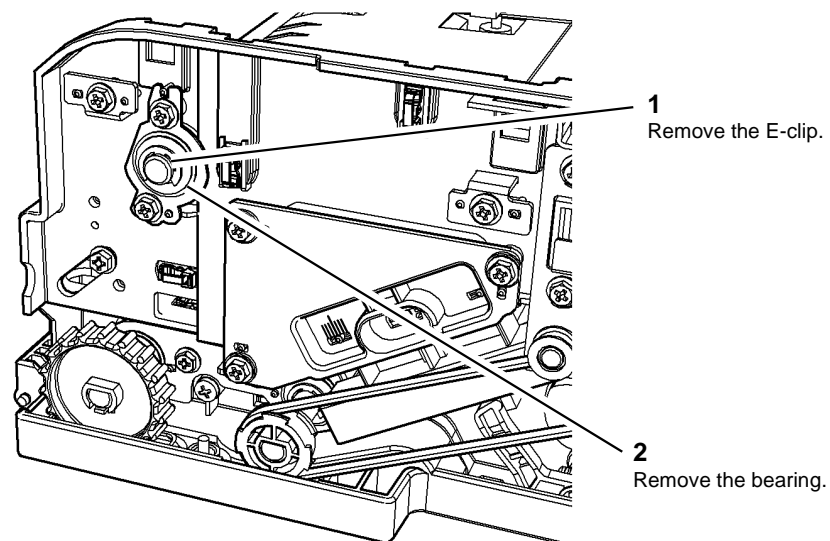
X-1-1862-A

4. Remove the front bearing, [Figure 1](#).

Figure 1 Front bearing removal

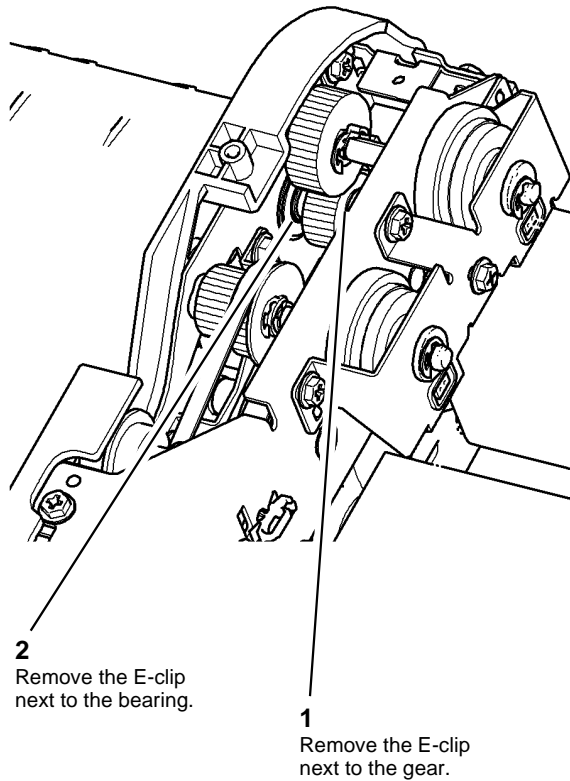
5. Remove the takeaway roll assembly, [Figure 2](#).

3
Slide the takeaway roll assembly forward to enable the gear and bearing to be removed.

4
Slide the takeaway roll assembly towards the front of the machine to clear the rear frame.

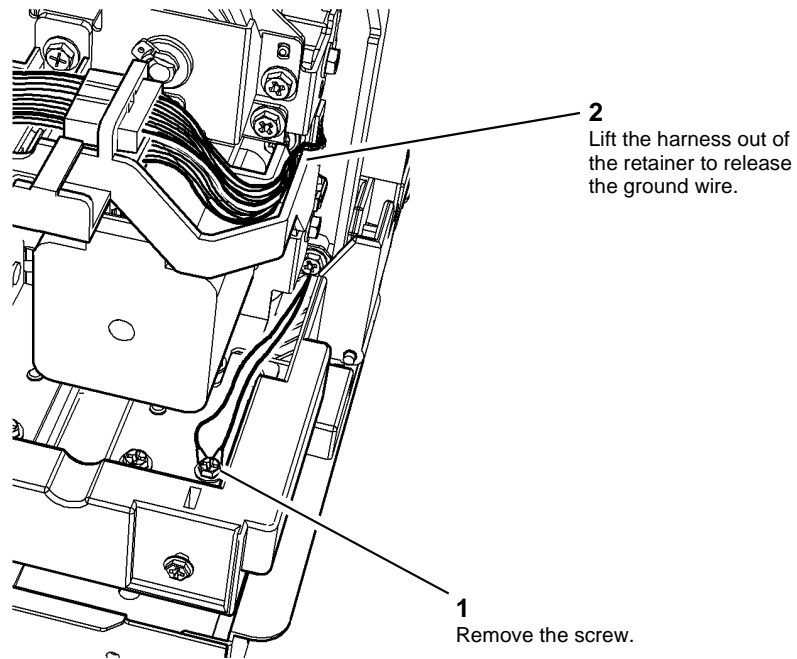
X-1-1844-A

3. Disconnect the ground wire, **Figure 1**.

Figure 1 Ground wire disconnection

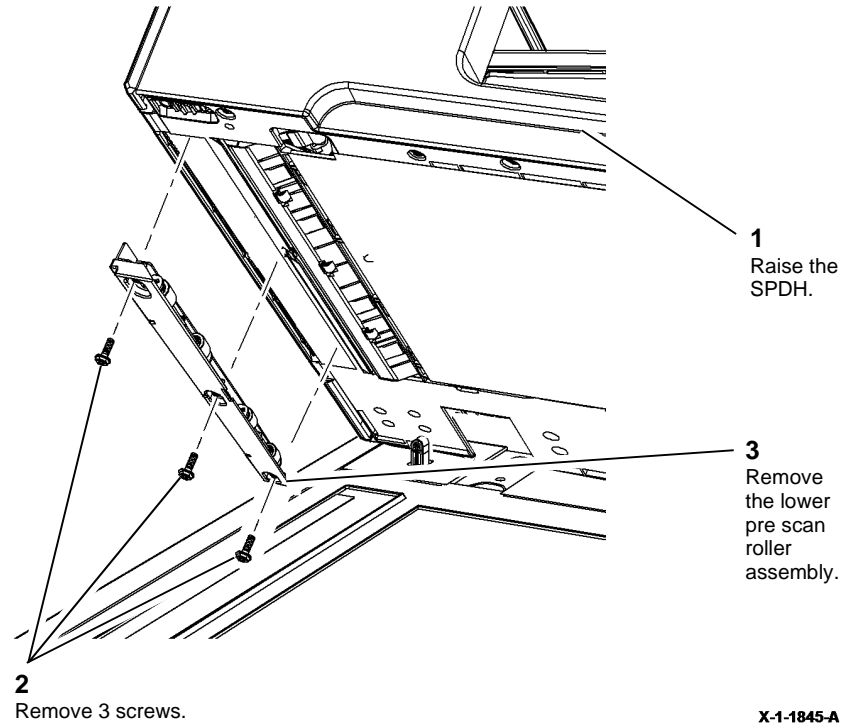
X-1-1845-A

4. Remove the lower pre scan roller assembly, **Figure 2**.

Figure 2 Lower pre scan roller assembly

Handle the lower pre scan assembly with care. The lower pre scan assembly is loosely assembled and contains 2 springs under compression. The assembly can spring apart on removal.

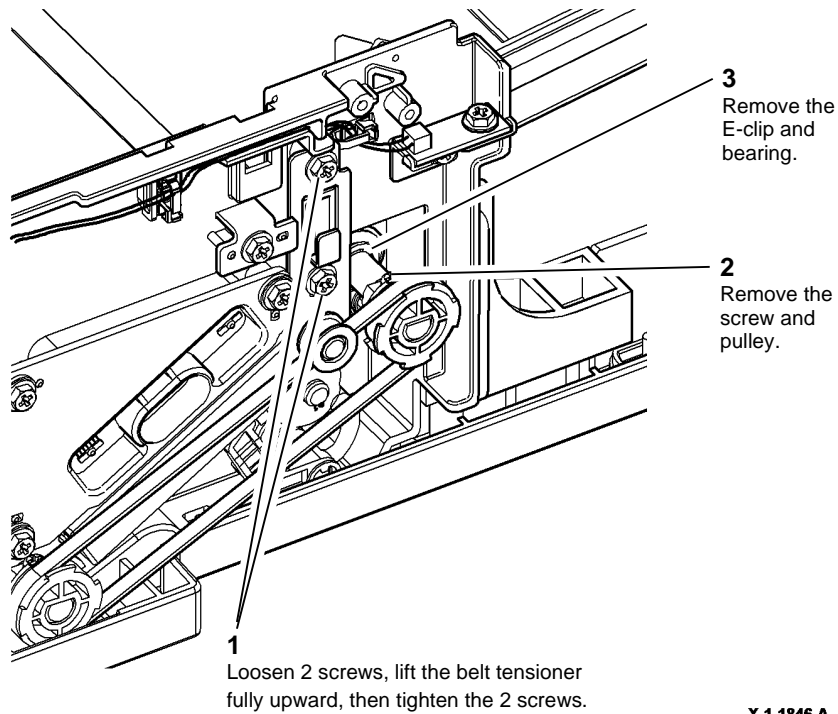
X-1-1846-A

1. Open the SPDH top cover assembly, [PL 5.20 Item 14](#).
2. Remove 5 screws then remove the SPDH rear cover, [PL 5.10 Item 1](#).
3. Remove 4 screws then remove the SPDH front cover, [PL 5.10 Item 17](#).
4. Remove the complete input tray assembly, [REP 5.23](#).
5. Remove the front components, [Figure 1](#).

Figure 1 Front components removal

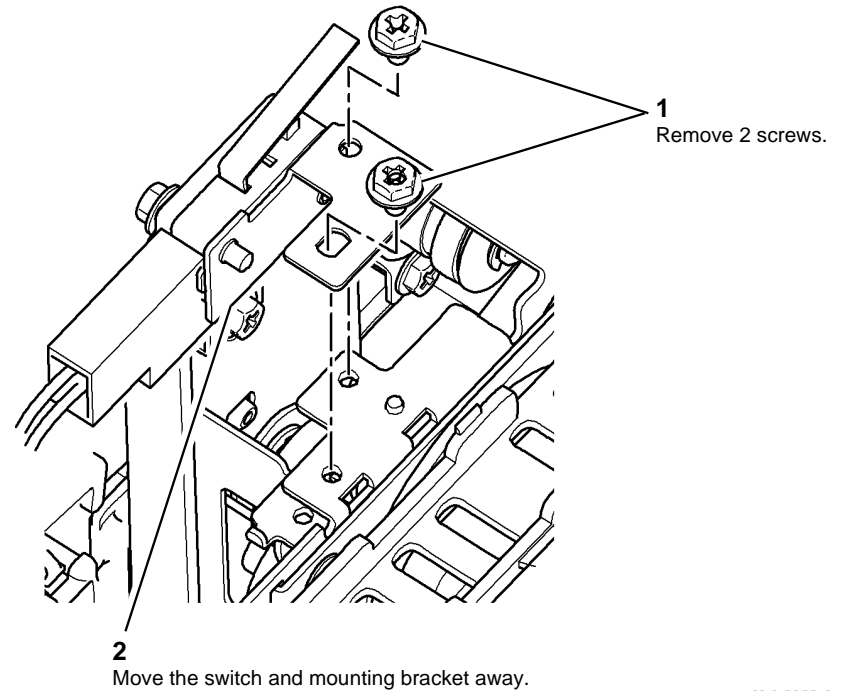
X-1-2023-A

6. Remove the SPDH top cover open switch, [Figure 2](#).

Figure 2 Switch removal

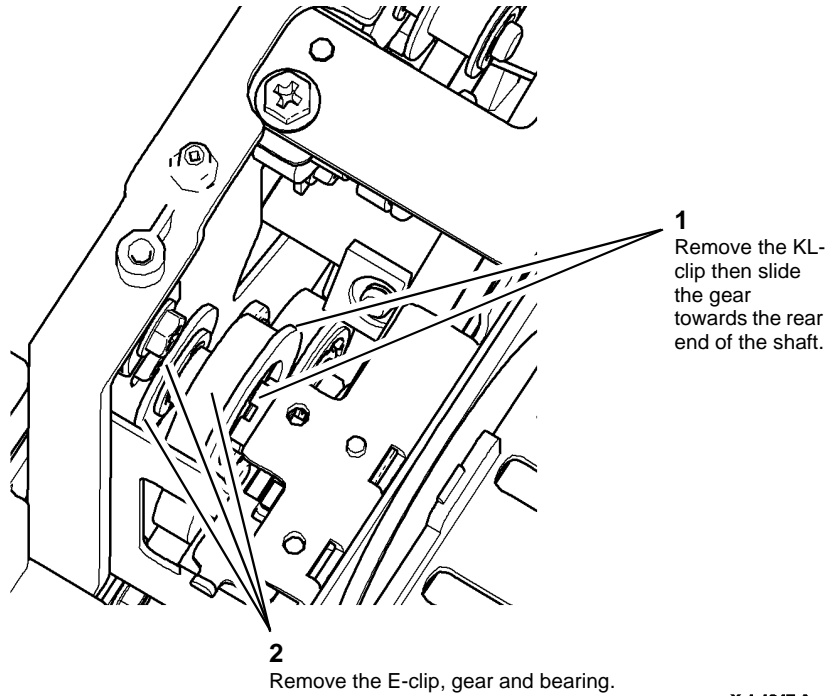
7. Remove the rear components, [Figure 3](#).

Figure 3 Rear components removal

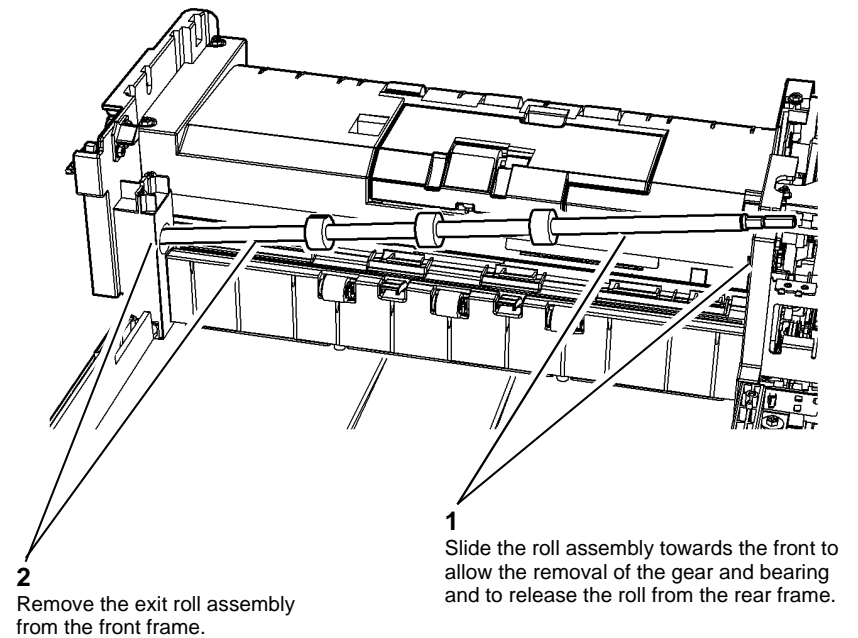
8. Remove the exit roll assembly, [Figure 4](#).

Figure 4 Exit roll assembly removal

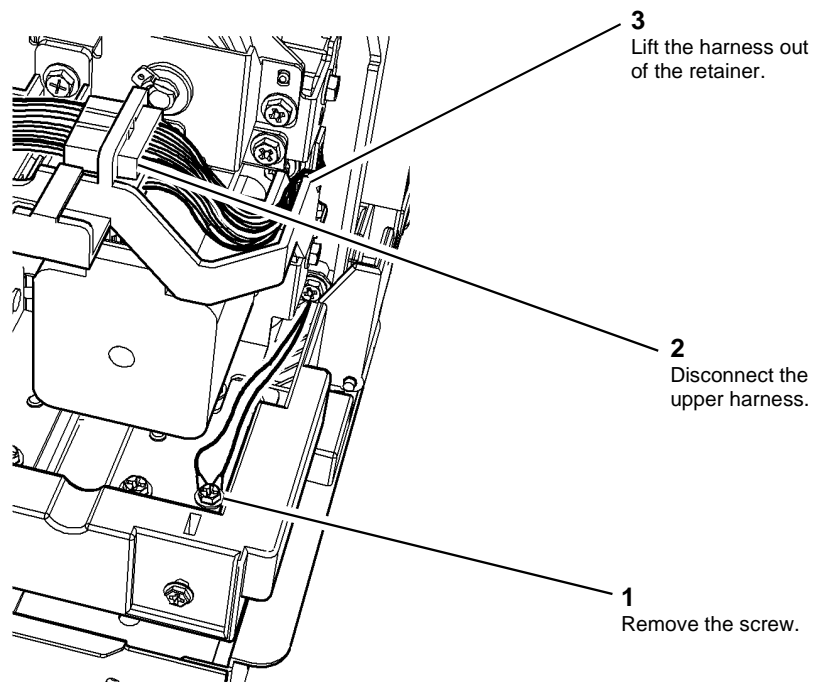
X-1-1849-A

1. Open the SPDH top cover assembly, [PL 5.20 Item 14](#).
2. Disconnect the harnesses, [Figure 1](#).

Figure 1 Ground wire disconnection

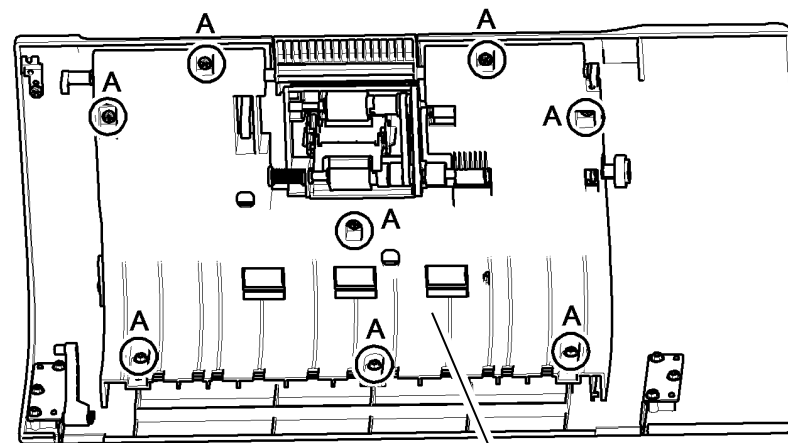
3. Remove the feed assembly frame, [Figure 2](#).

1. Remove 8 screws marked A.

2. Remove the feed assembly.

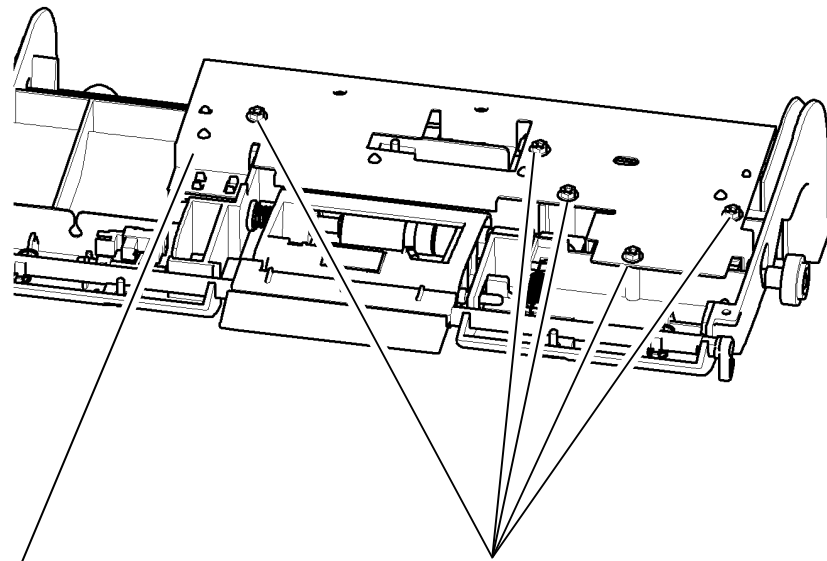
4. Prepare to remove the sensors, [Figure 3](#).

2
Raise the mounting plate to give access to the sensors and connectors.

1
Remove 5 screws.

Figure 3 Preparation

- 2** Insert and tighten the five screws, refer to Figure 3 and the CAUTION.
- 1** Position the springs between the mounting plate and the nip shaft.

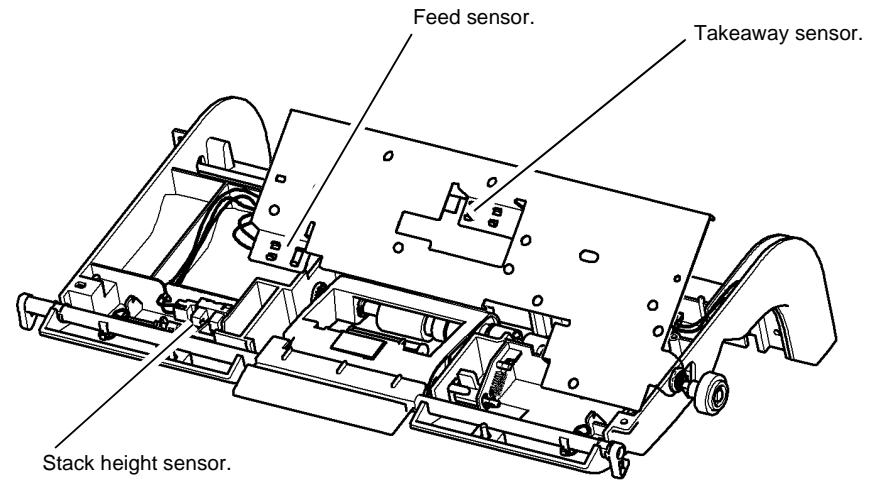
X-1-1852-A

5. Remove the appropriate sensor, [Figure 4](#).

1
Disconnect the sensor harness, remove 1 screw or release the sensor legs, then remove the appropriate sensor.

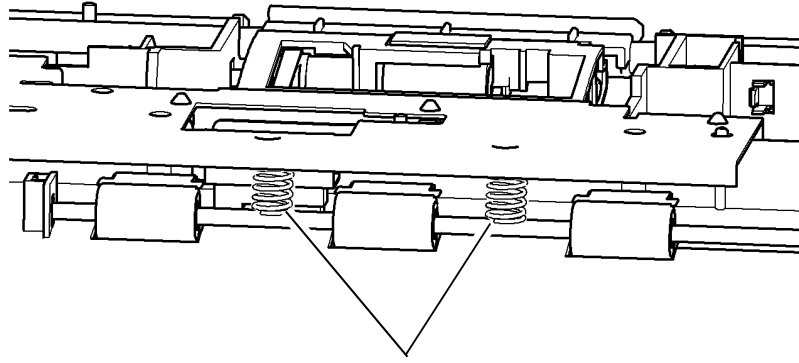
X-1-1853-A

1. The replacement is the reverse of the removal procedure.
2. Ensure the nip roll springs are correctly located, Figure 5.

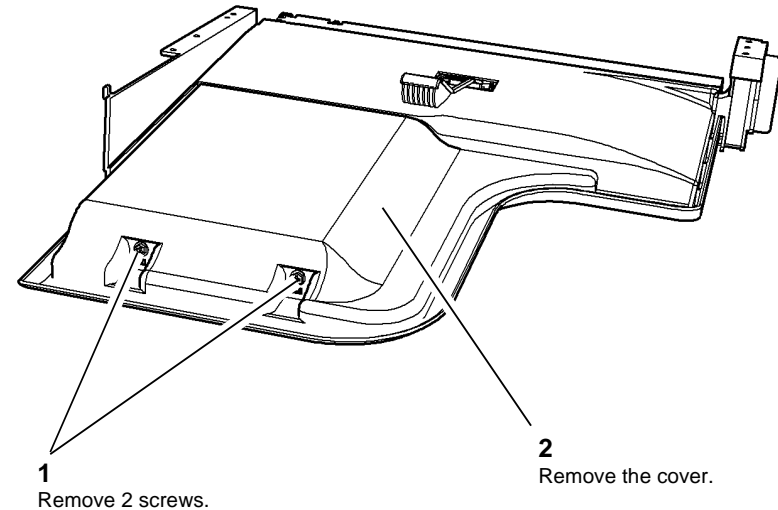
1. Remove the complete input tray assembly, REP 5.23.
2. Turn the input tray assembly upside down.
3. Remove the length sensors cover, Figure 1.

- 1** Remove 2 screws.

- 2** Remove the cover.

Figure 1 Cover removal

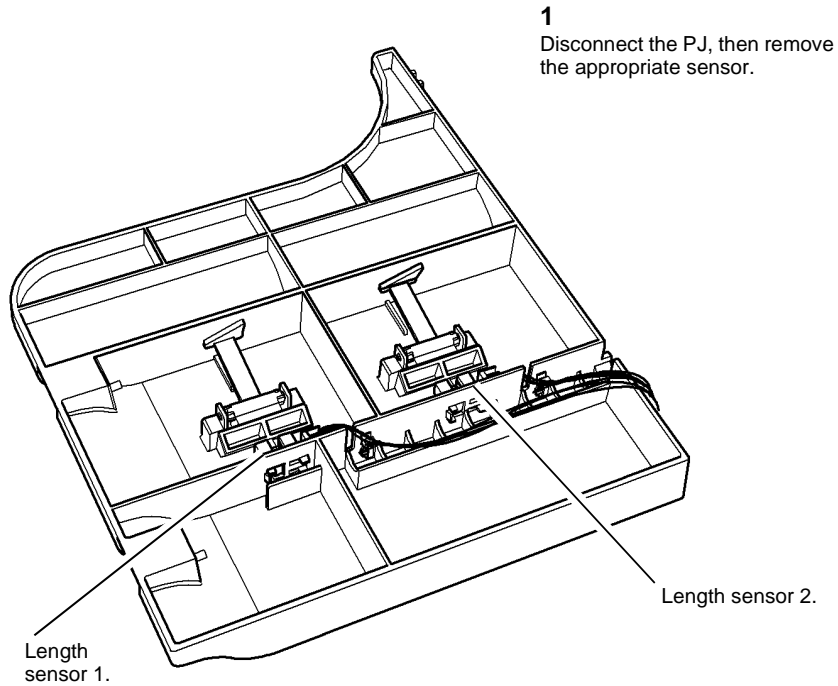
X-1-1802-A

- Remove the appropriate length sensor, [Figure 2](#).

Figure 2 Length sensors removal

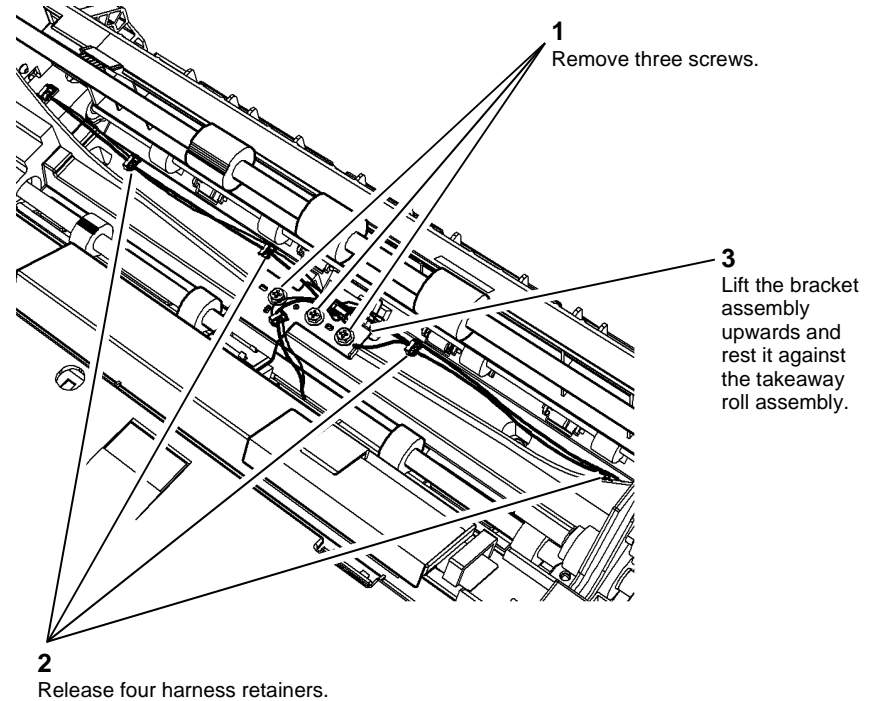
X-1-1854-A

- Remove the separation assembly, [REP 5.3](#).
- Prepare to remove the reg sensors, [Figure 1](#).

Figure 1 Preparation

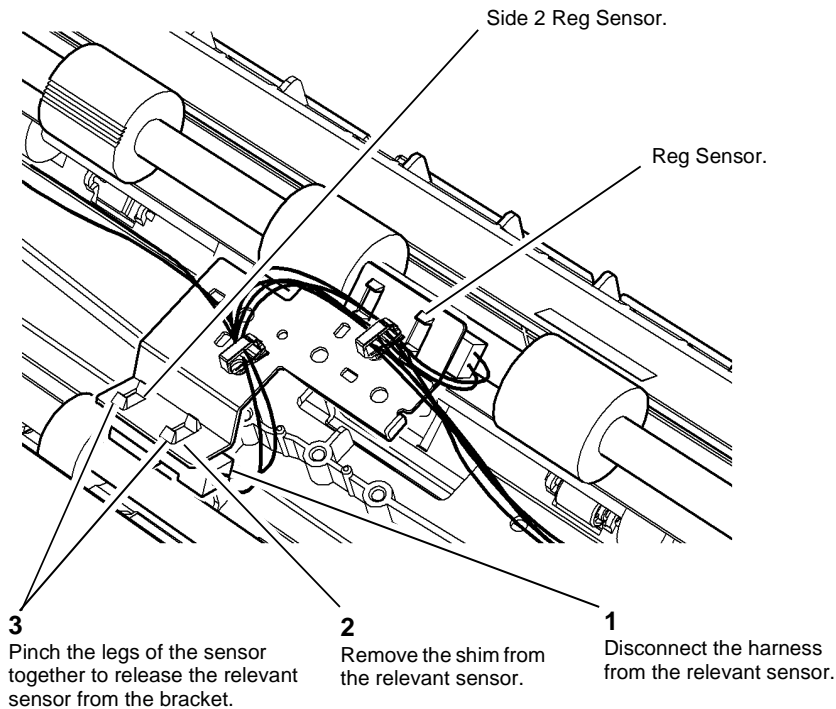
X-1-1855-A

- Remove the appropriate reg sensor, [Figure 2](#).

Figure 2 Sensor assembly removal

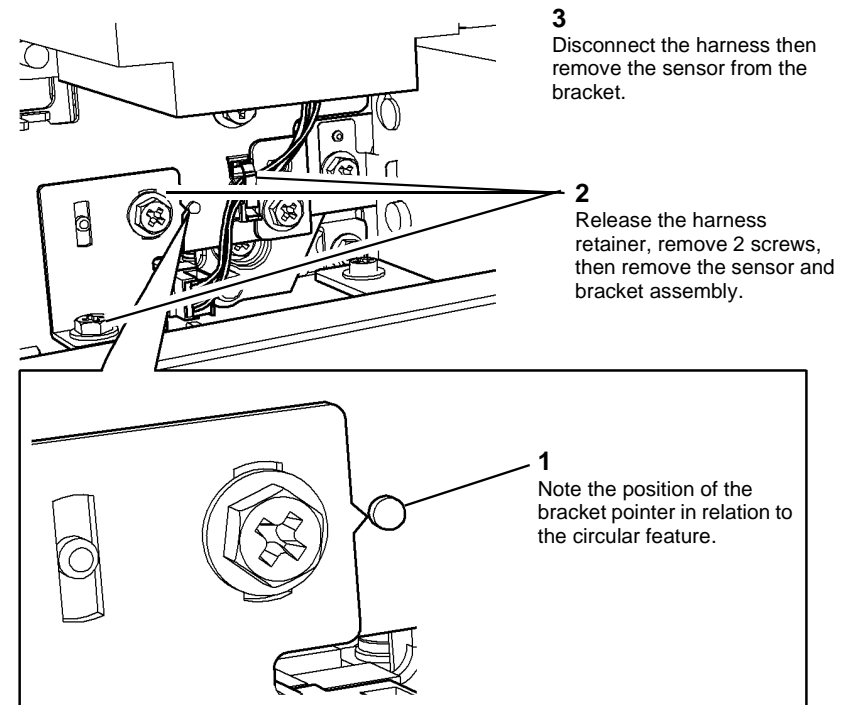
X-1-1856-A

- If necessary rotate the exit jam clearance knob, [PL 5.17 Item 5](#), so that the flag is not within the gap of the sensor.
- Remove the calibration home position sensor, [Figure 1](#).

Figure 1 Sensor removal

1. The replacement is the reverse of the removal procedure.
2. When installing the sensor and bracket assembly, ensure that the pointer on the bracket is accurately aligned with the circular feature as noted in [Figure 1](#) step 1.
