708P91368
September 2017

Xerox® AltaLink® B8090 Family Multifunction Printer Service Manual

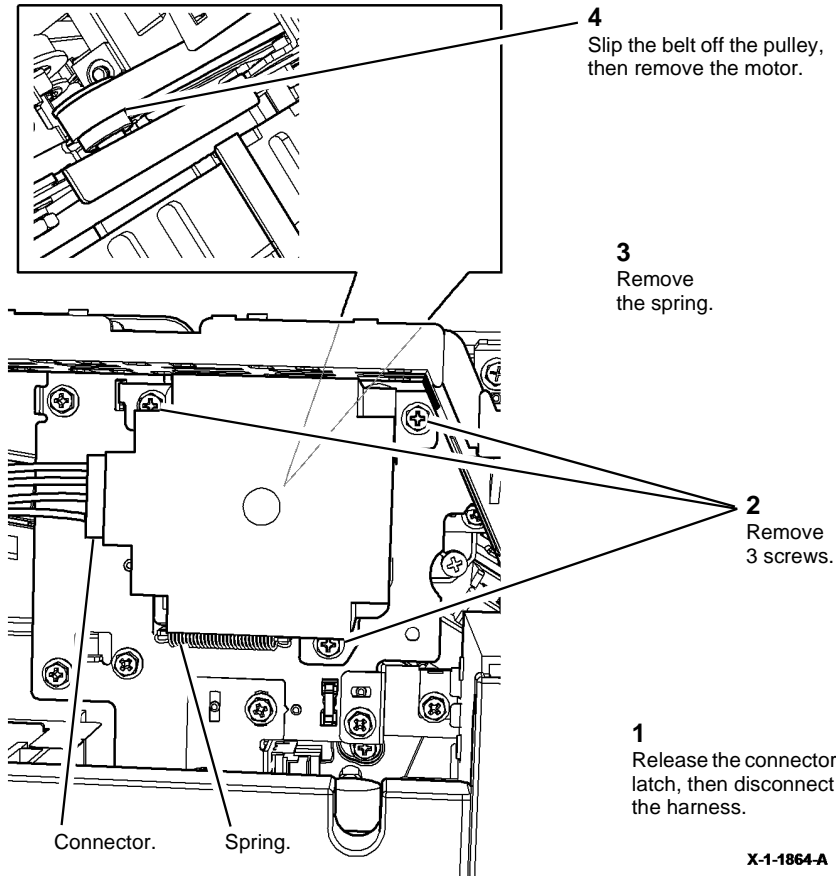
- Remove the feed motor, [Figure 1](#).

Figure 1 Feed motor removal

- Position the motor in the loop of the drive belt.
- Insert, but do not tighten the 3 screws.
- Attach the spring to correctly tension the drive belt, then tighten the 3 screws.
- The remainder of the replacement is the reverse of the removal procedure.

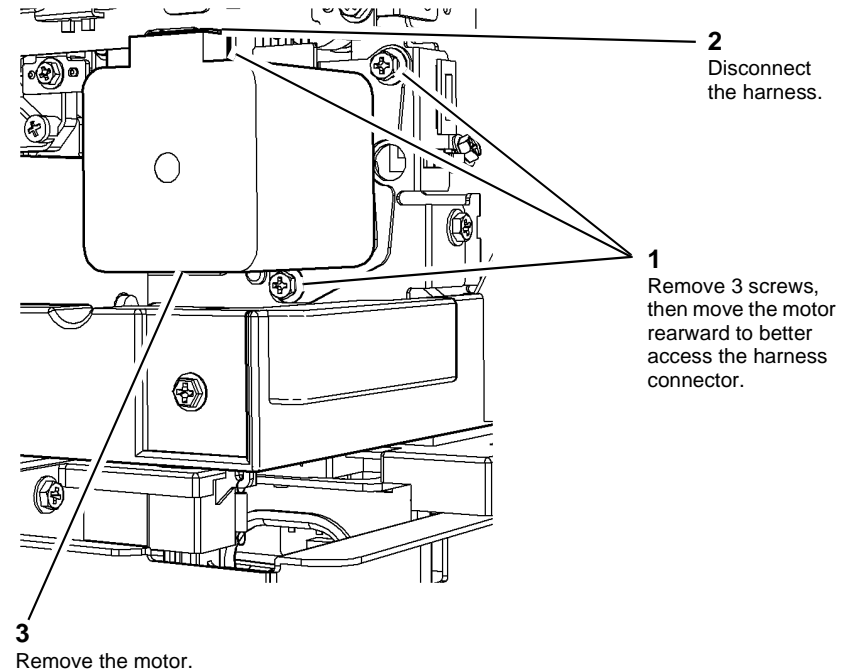
- Open the SPDH top cover assembly, [PL 5.20 Item 14](#).
- Remove 5 screws then the SPDH rear cover, [PL 5.10 Item 1](#).
- Remove the read motor, [Figure 1](#).

Figure 1 Read motor removal

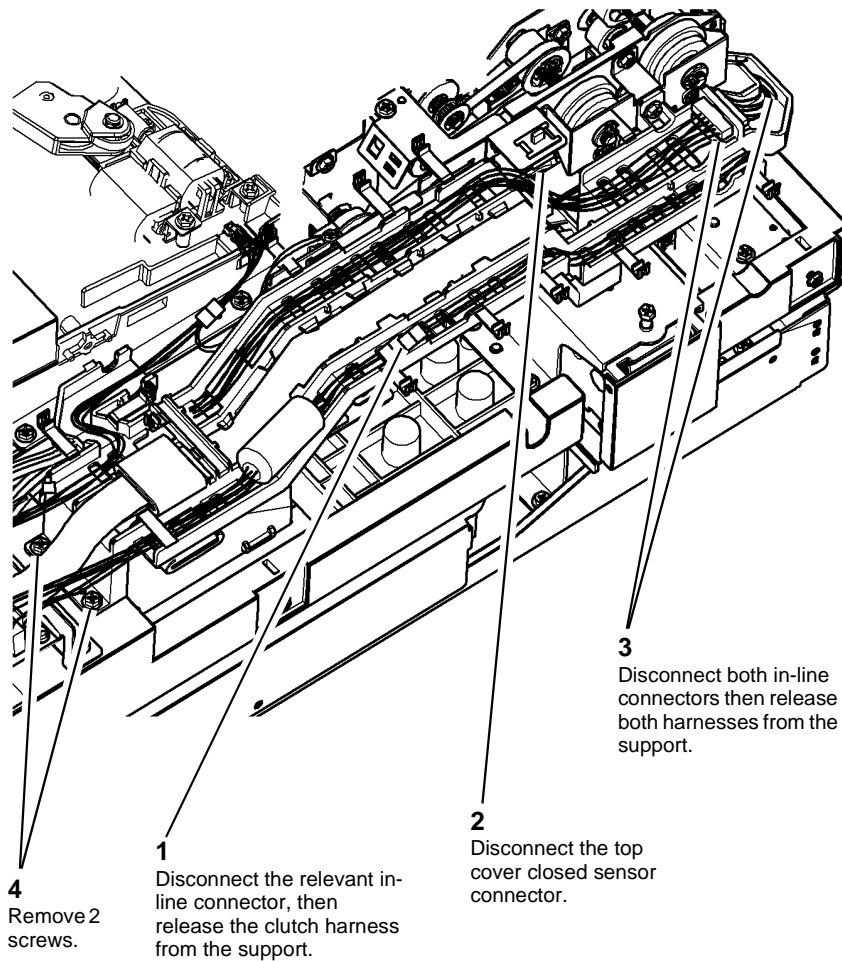
X-1-1866-A

3. Prepare to remove the feed clutch and/or the takeaway clutch, **Figure 1**.

Figure 1 Preparation

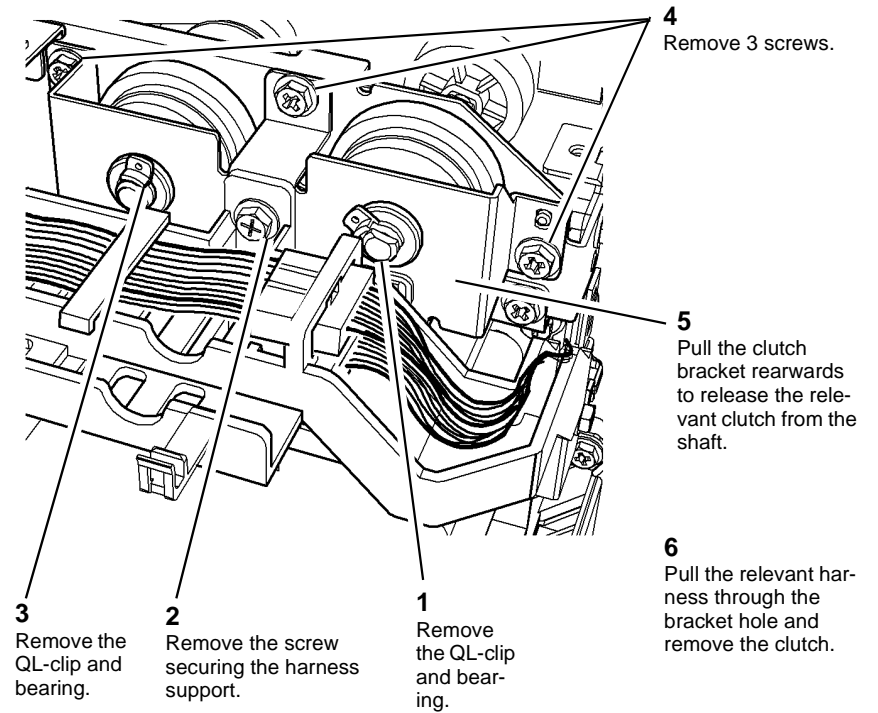
X-1-1867-A

4. Remove the feed clutch and/or the takeaway clutch, **Figure 2**.

Figure 2 Clutch removal

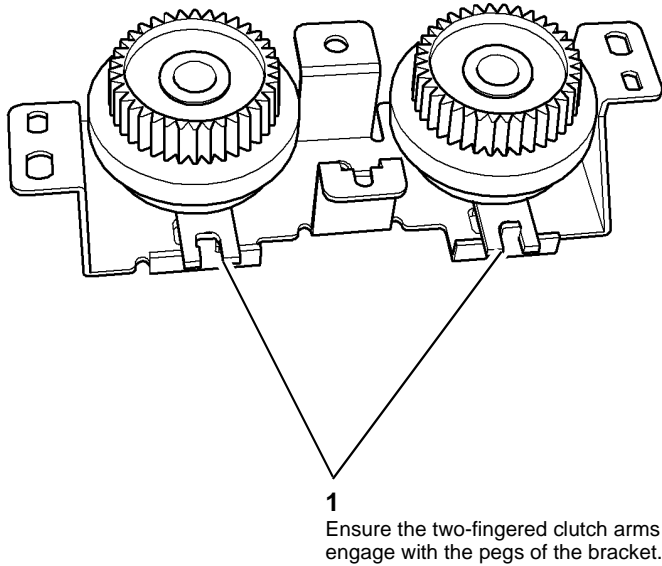
X-1-1868-A

1. The replacement is the reverse of the removal procedure.
2. Ensure the feed clutch engages correctly with the bracket, Figure 3.

Figure 3 Clutch locator

When installing the rear cover, ensure that the cover is lowered vertically into place so that the feed assembly drive belt, PL 5.19 Item 13 is not pushed off the pulley by the protrusion on the rear cover.

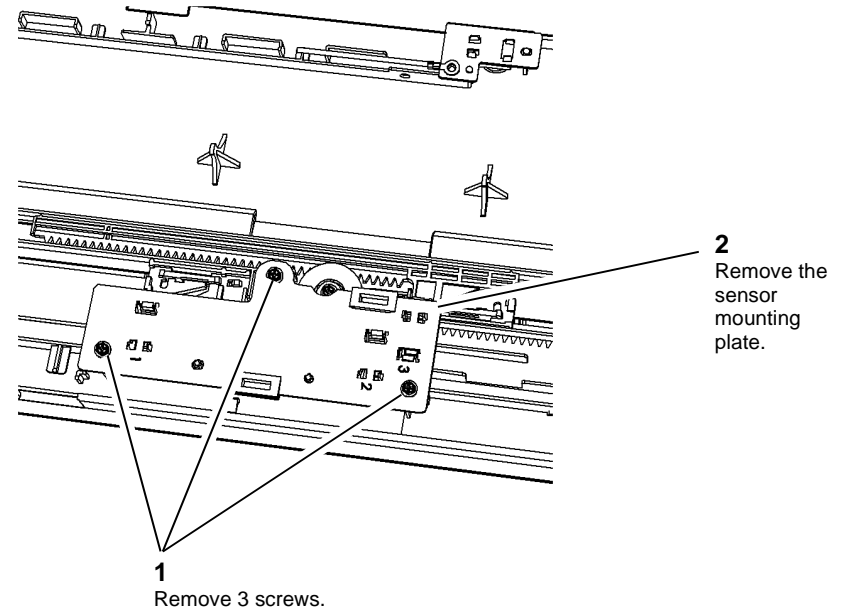
X-1-1803-A

2. Remove the sensor mounting plate, Figure 1.

Figure 1 Mounting plate removal

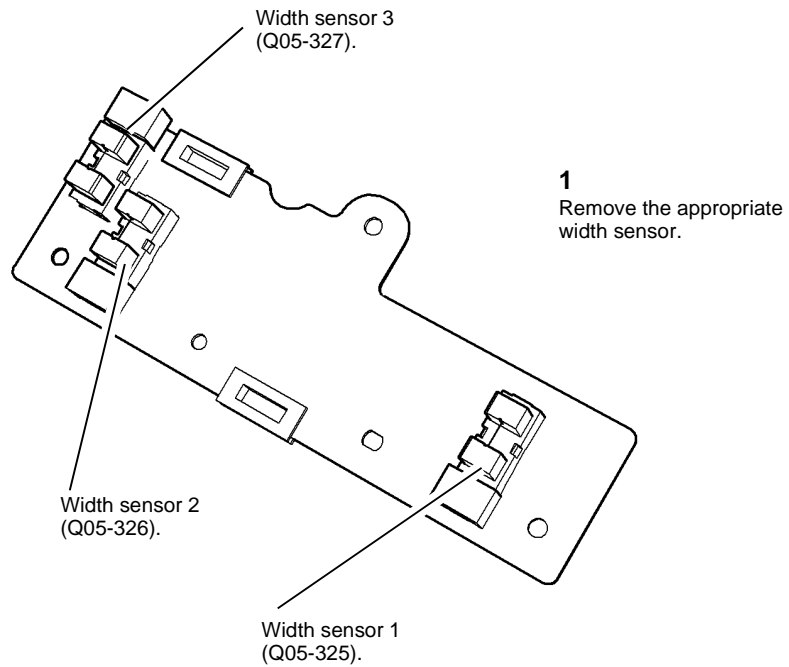
X-1-1804-A

3. Remove the document width sensors, [Figure 2](#).

Figure 2 Width sensors removal

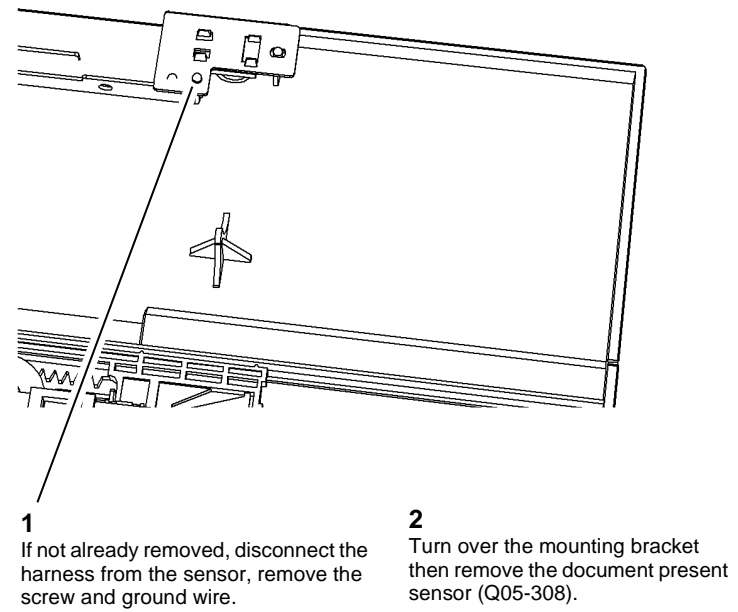
X-1-1805-A

4. Remove the document present sensor, [Figure 3](#).

Figure 3 Sensor removal

NOTE: If only the doc present sensor is being removed, it is not necessary to remove the input tray sensors or wiring. Hold the input tray in a vertical position to give access to the doc present sensor, then continue at Figure 3.

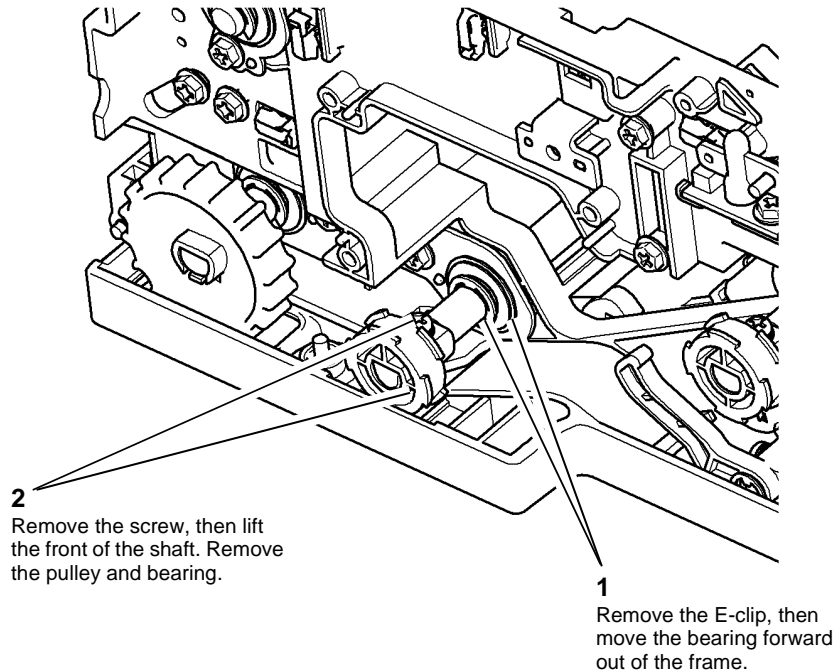
X-1-1873-A

1. Remove the side 2 scan assembly, [REP 60.6](#).
2. Remove 5 screws then remove the SPDH rear cover, [PL 5.10 Item 1](#).
3. Prepare to remove the mid scan roll assembly, [Figure 1](#).

Figure 1 Preparation

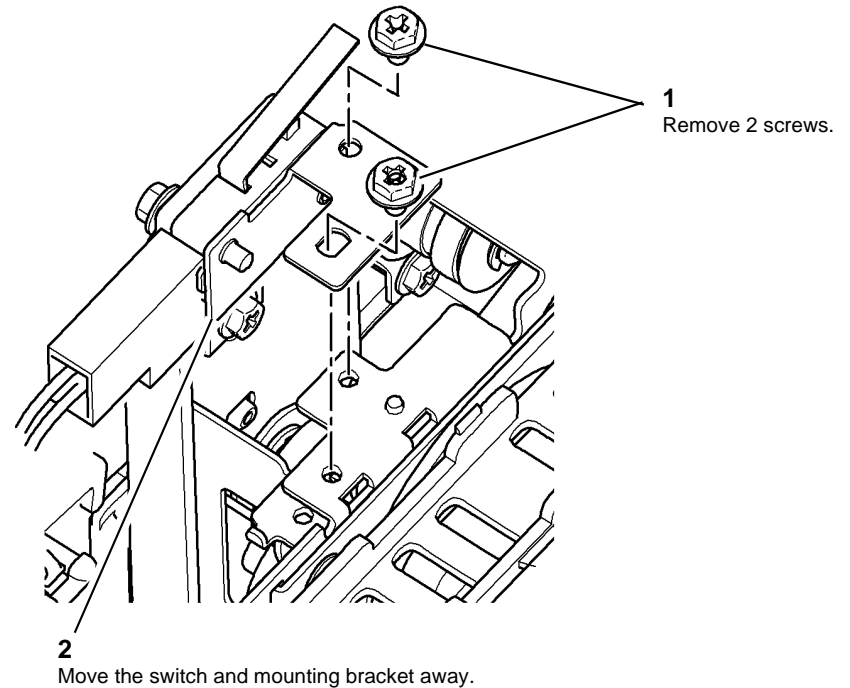
X-1-2024-A

4. Remove the SPDH top cover open switch, [Figure 2](#).

Figure 2 Switch removal

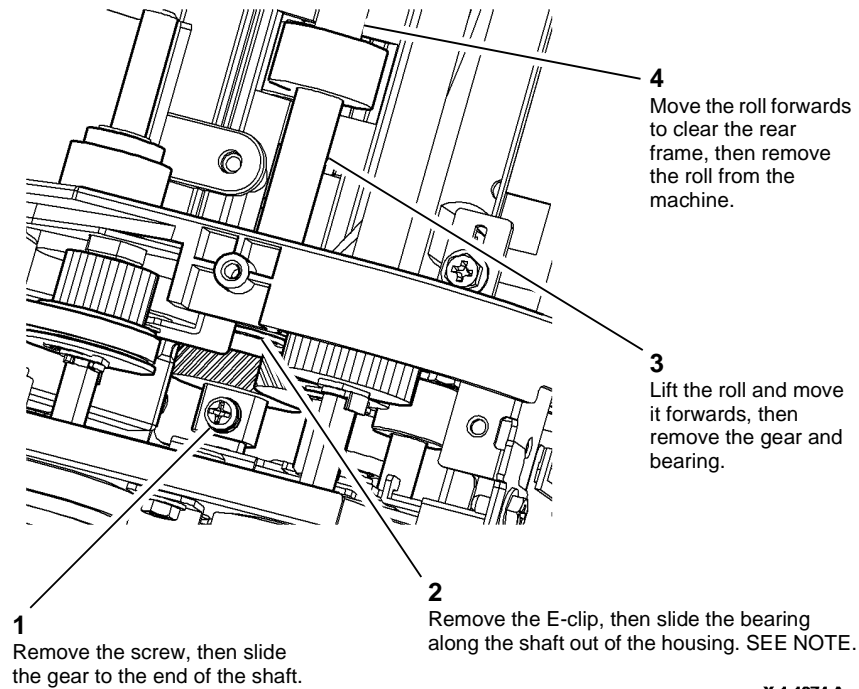
X-1-1874-A

6. Remove the mid scan roll assembly, [Figure 3](#).

NOTE: At step 2 [Figure 3](#), pull the E-clip from the shaft using a spring removing tool and a magnetic retriever tool.

Figure 3 Mid scan roll removal

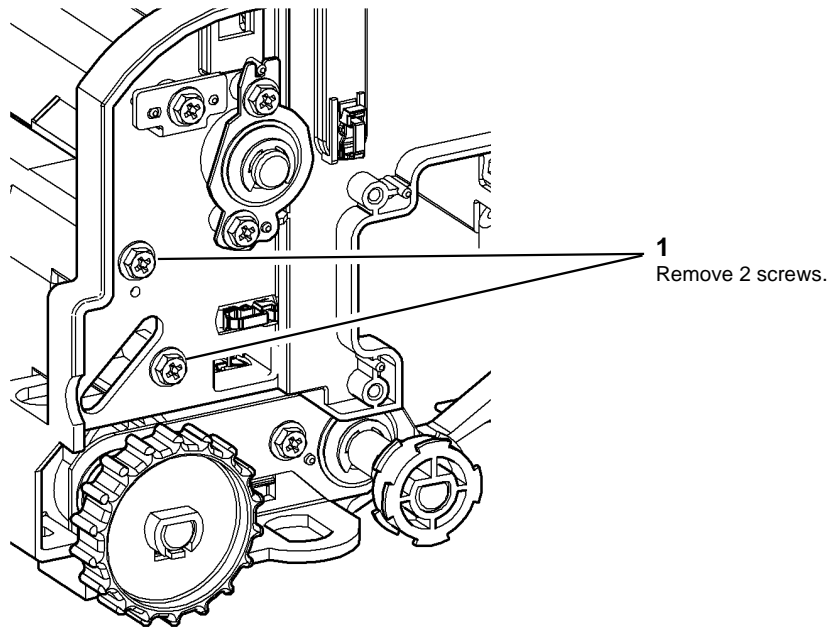
X-1-1891-A

1. Perform [REP 5.22](#) up to and including step 4.
2. [Figure 1](#), release the document guide front fixings.

Figure 1 Document guide front fixings

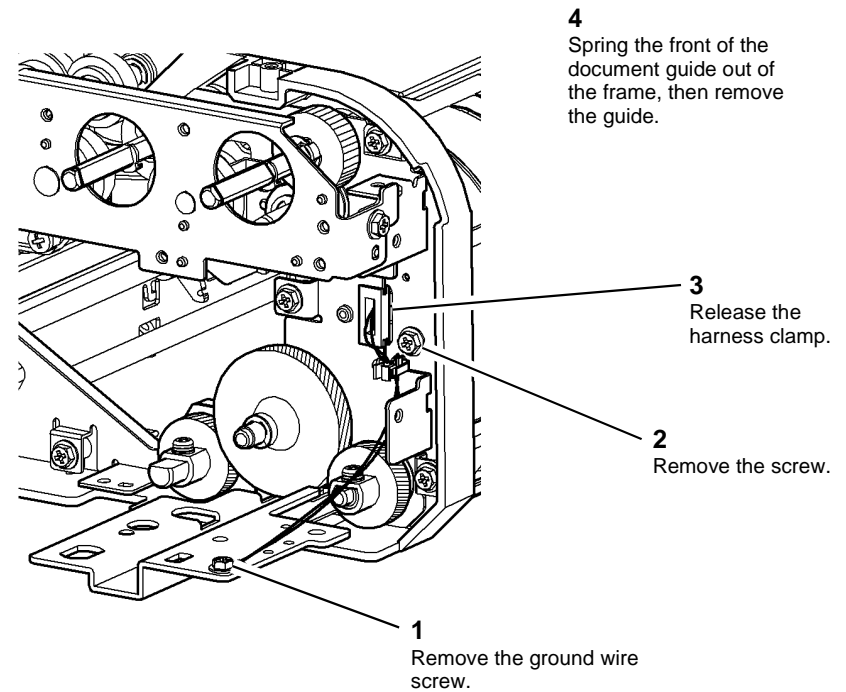
X-1-1892-A

3. [Figure 2](#), remove the document guide.

Figure 2 Document guide removal

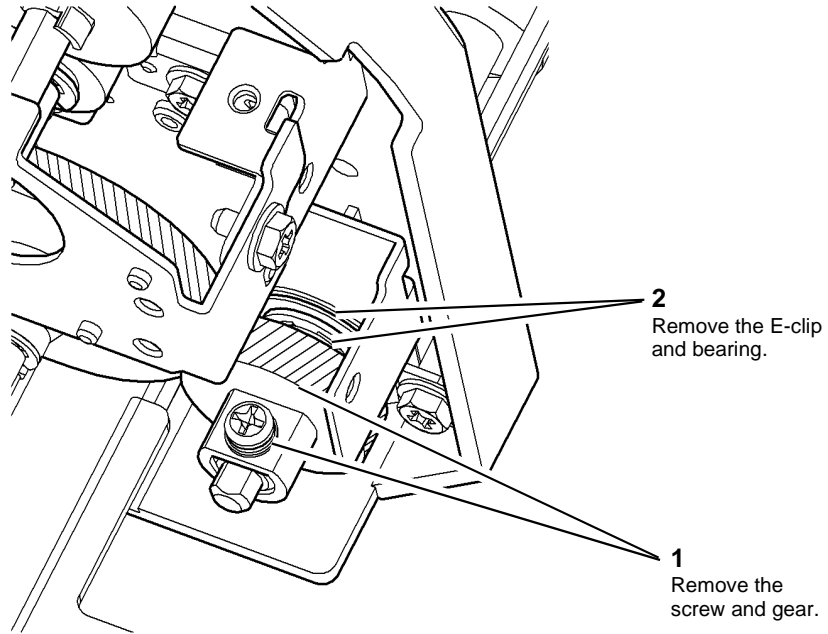
X-1-1893-A

4. **Figure 3**, remove the rear bearing.

Figure 3 Rear bearing removal

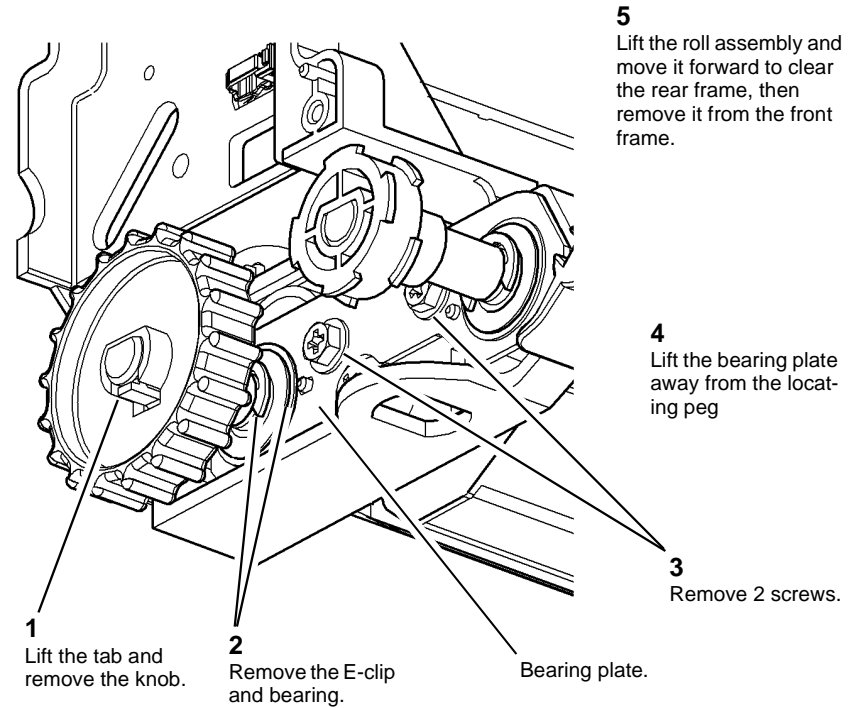
X-1-1894-A

5. **Figure 4**, remove the pre scan roll assembly.

Figure 4 Roll assembly removal

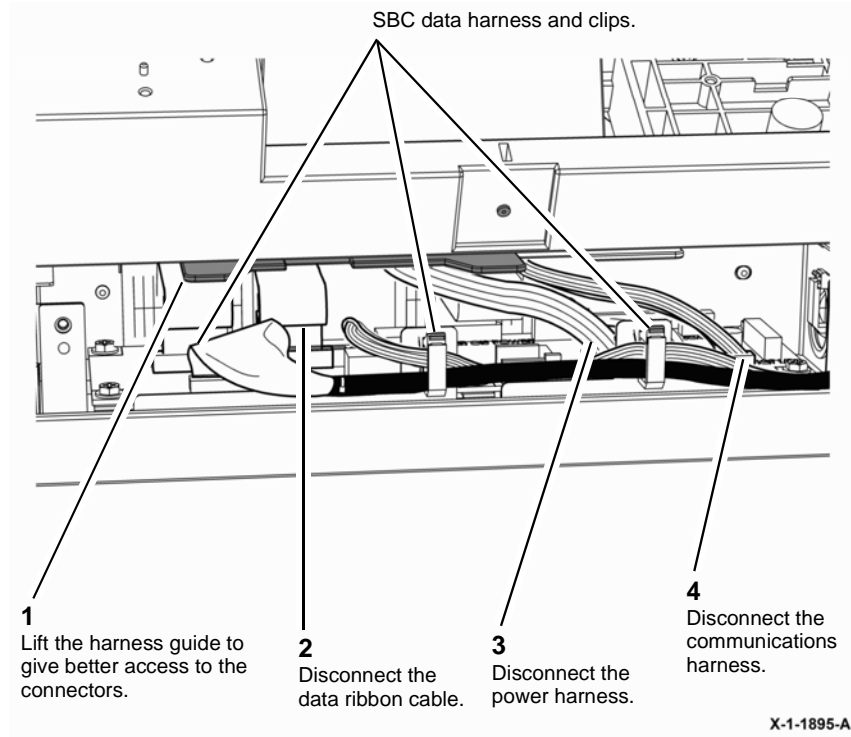
- a. Disconnect the SBC data harness.
- b. Release the clips securing the SBC data and power harnesses.
- c. Remove the 2 screws securing the scanner PWB chassis.
- d. Move the scanner PWB and chassis rearwards for improved access to the PWB connectors.

Figure 1 SPDH to Scanner Connections

NOTE: If improved access to the PWB connectors is required, refer to [REP 60.4](#), and perform the steps that follow:

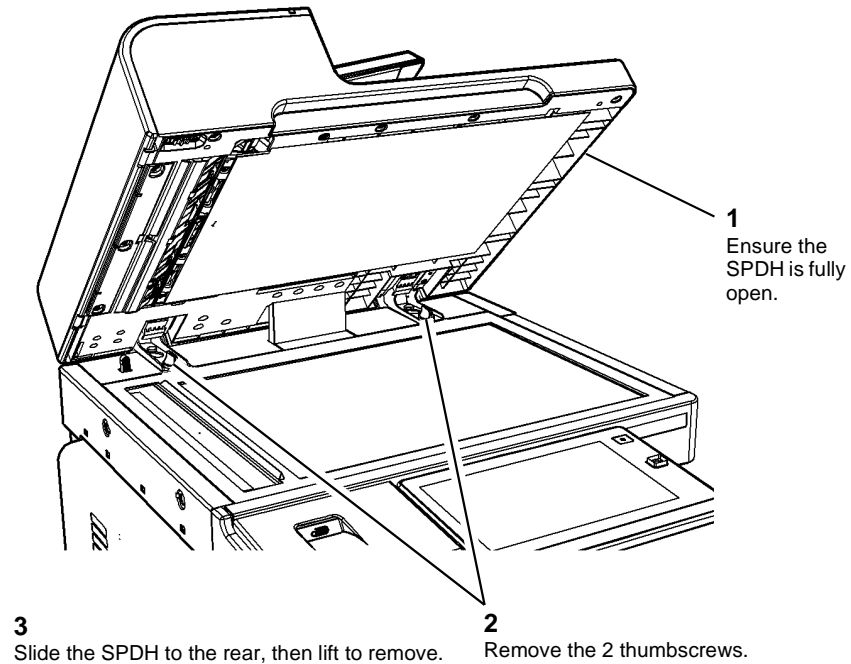
X-1-1896-A

- Stand at the rear of the machine, remove the SPDH, [Figure 2](#).

Figure 2 SPDH removal

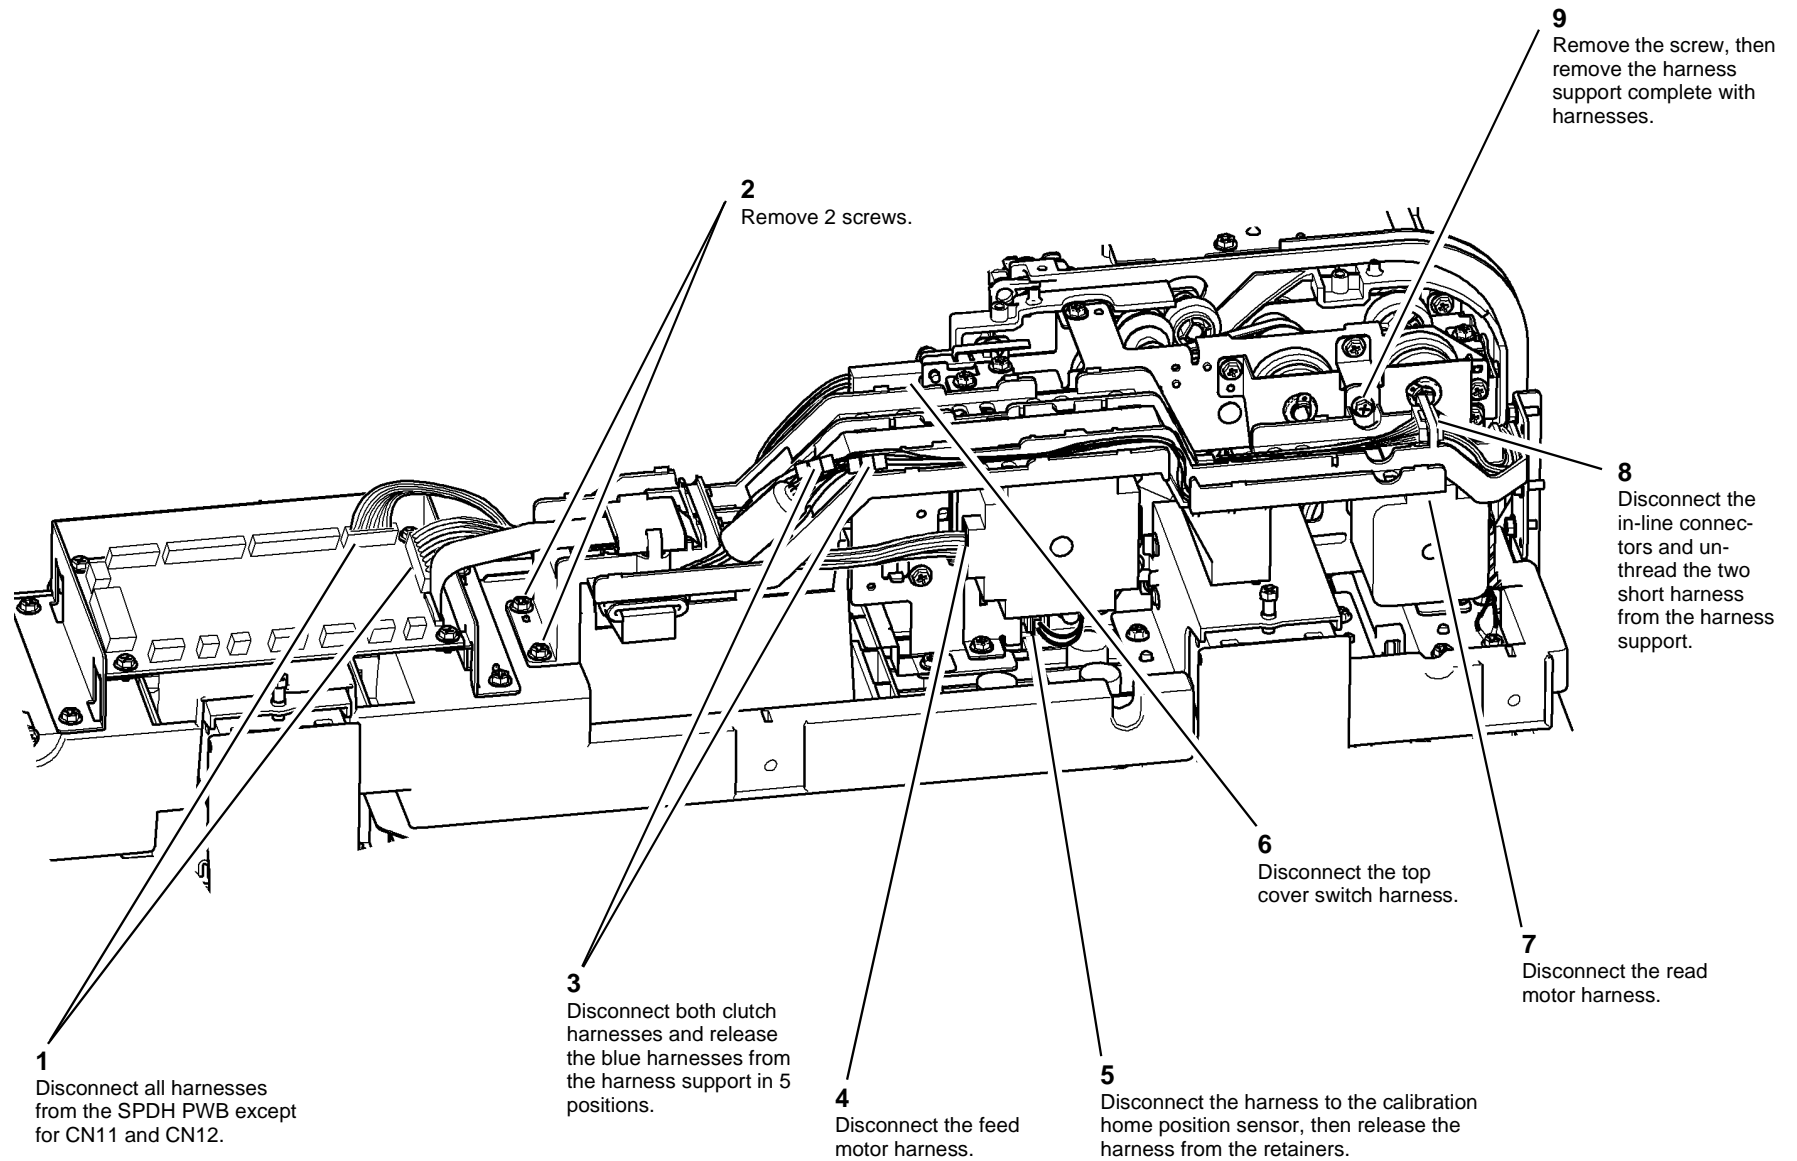
X-1-2025-A

1. Remove the scanner rear cover and faraday shield, [REP 60.1](#).
2. Refer to [REP 5.18](#), figure 1, Disconnect the data ribbon cable only from the scanner PWB, by following the procedure up to steps 1 and 2.
3. Disconnect the ribbon cables from the side 2 scanner, refer to [REP 60.6](#). Perform the procedure up to step 5, but do not remove the rear fixing screw (step 4 in figure 1 of the procedure).
4. Remove the harness assembly, [Figure 1](#).

Figure 1 Harness assembly removal

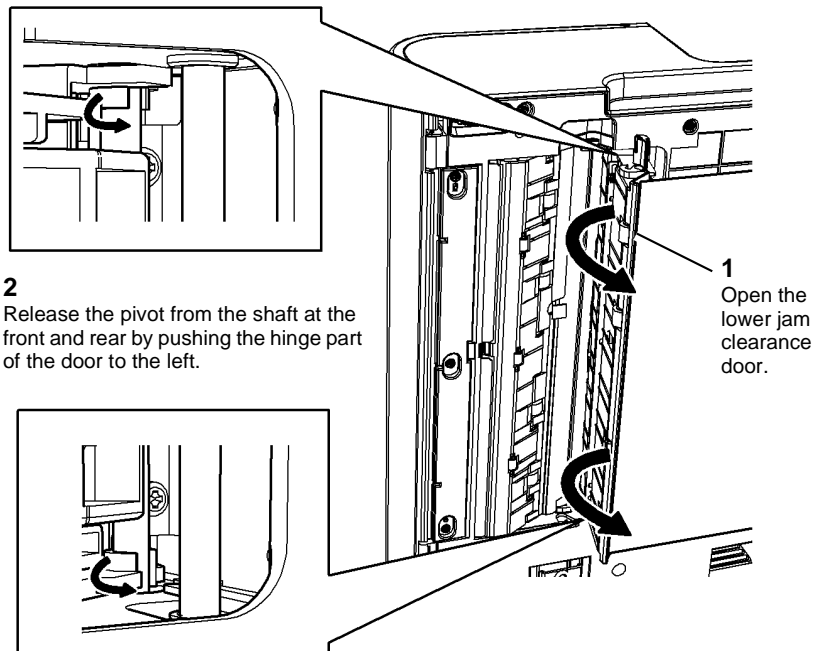
X-1-1990-A

1. Release the lower jam clearance door, [Figure 1](#).

Figure 1 Jam clearance flap release

During steps 2 and 3, support the weight of the lower jam clearance door to prevent damage to the document pad and document pad fixings.

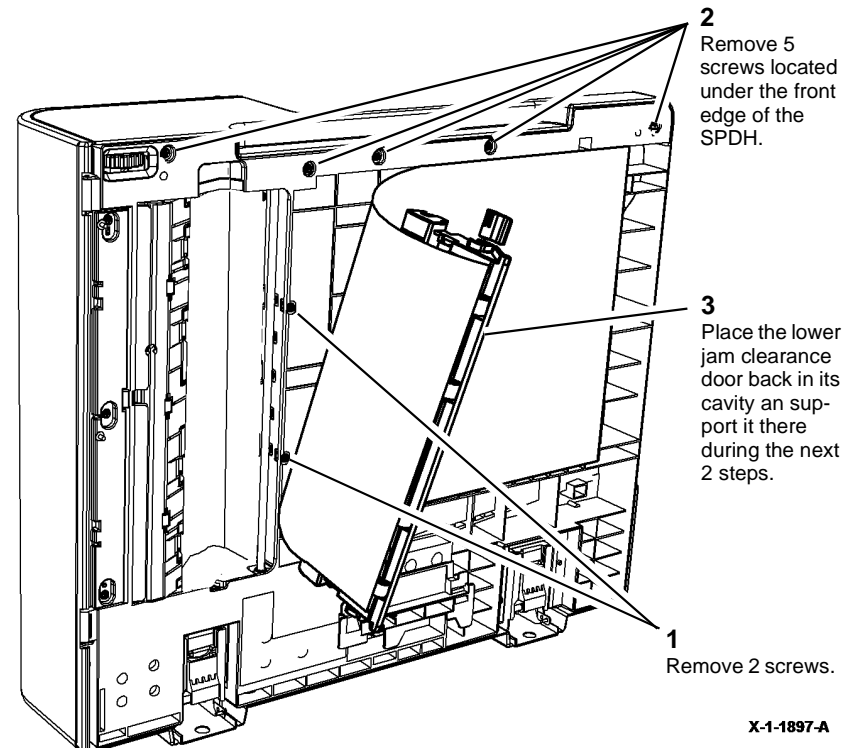
X-1-1897-A

2. Remove the lower fixings, [Figure 2](#).

Figure 2 Lower fixings removal

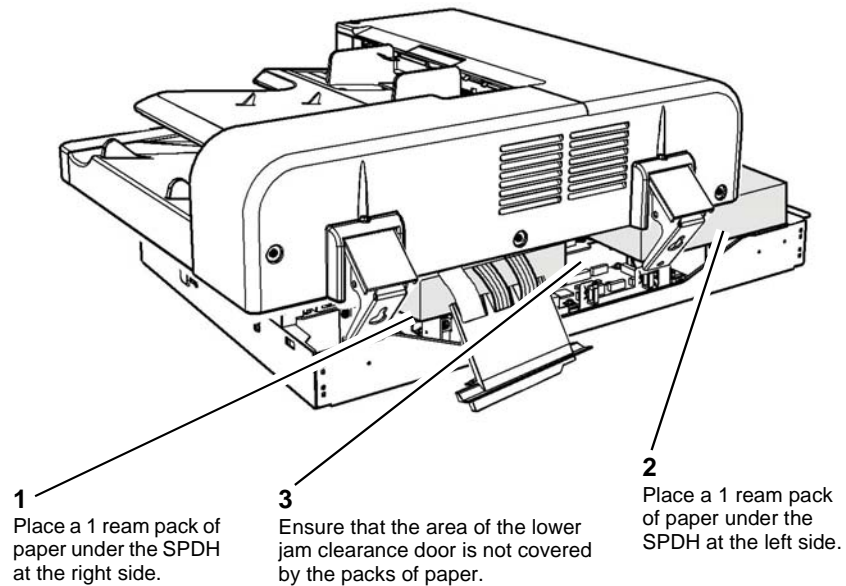
X-1-1898-A

- Support the removed SPDH on top of the machine, [Figure 3](#).

Figure 3 Supporting the SPDH

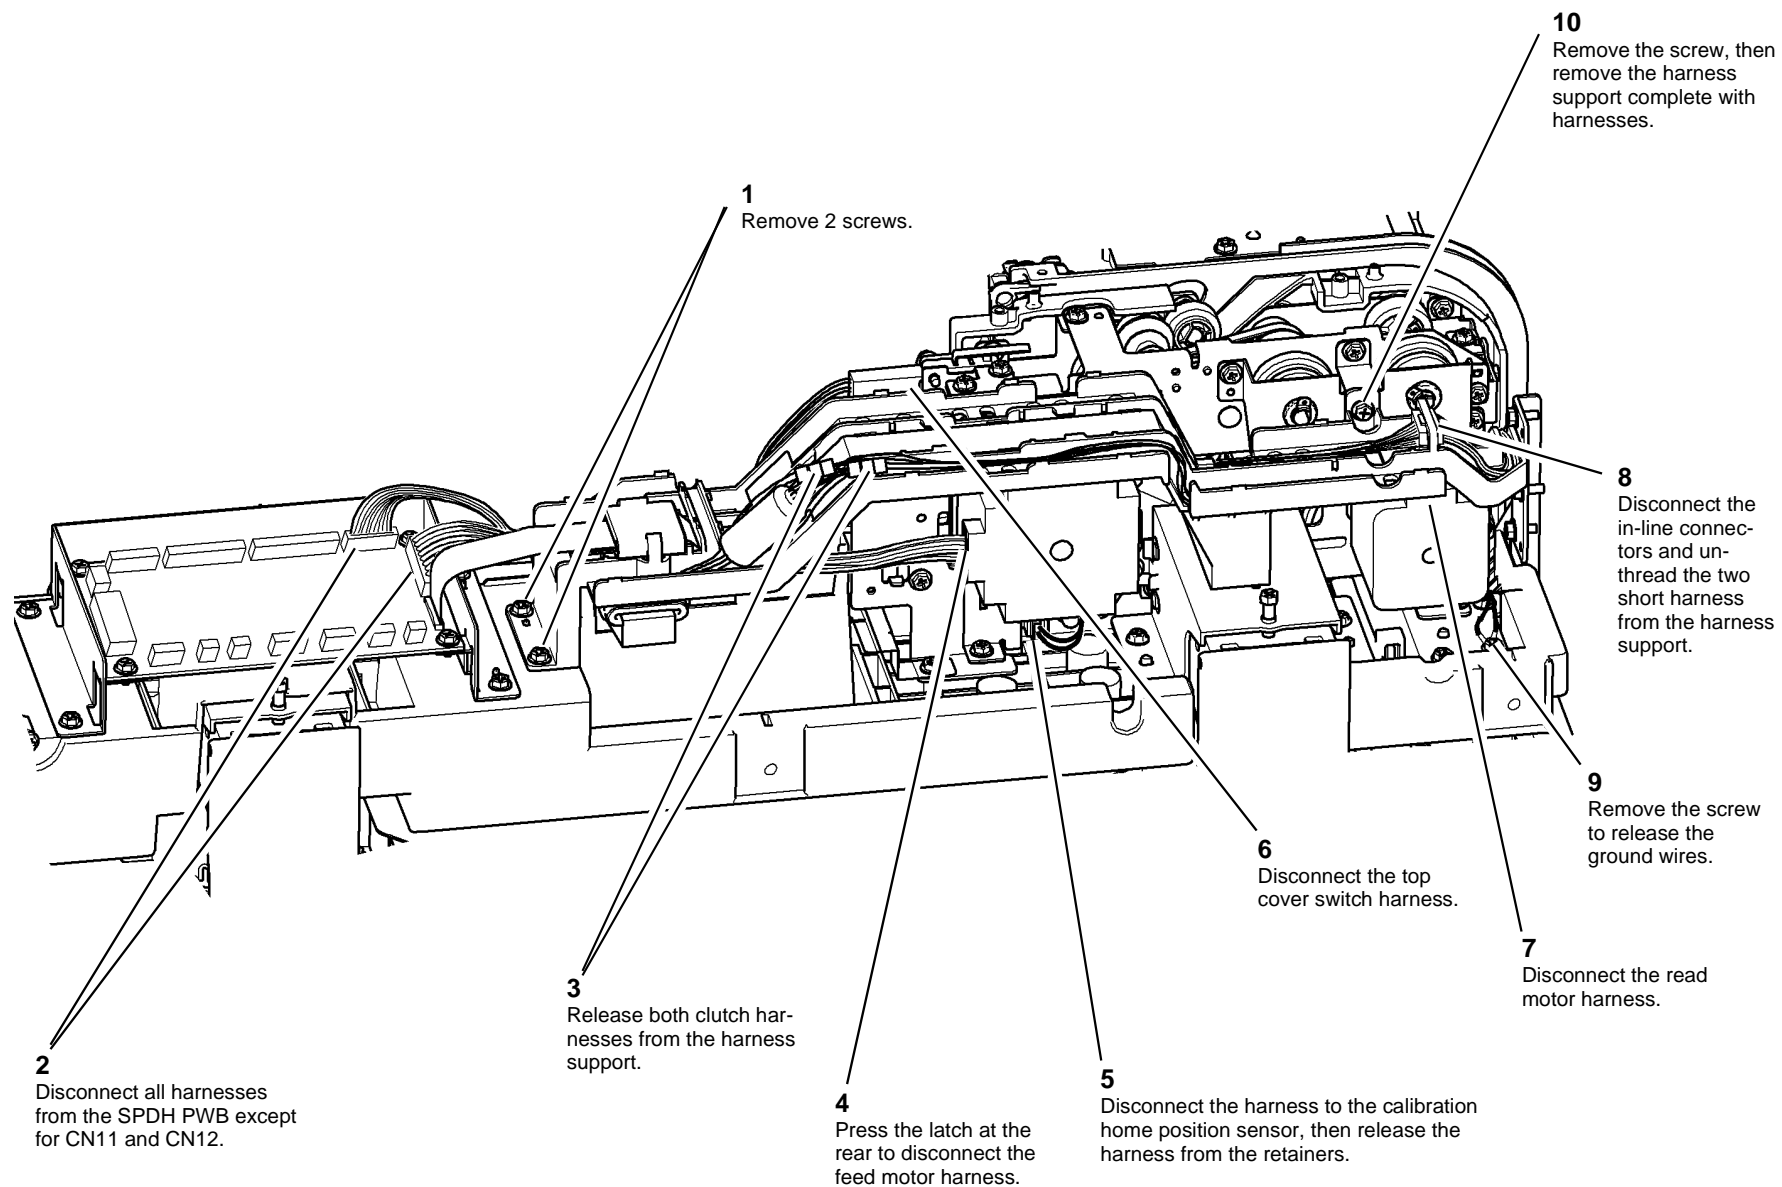
X-1-2025-A

8. Remove the harness support, [Figure 4](#).

Figure 4 Harness support removal

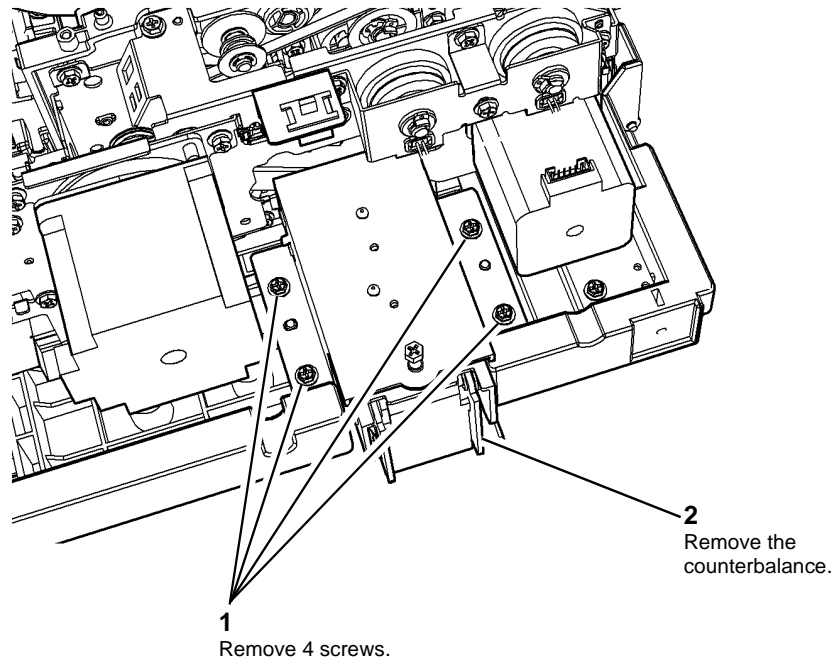
X-1-1900-A

9. Remove the left counterbalance, [Figure 5](#).

Figure 5 Left counterbalance removal

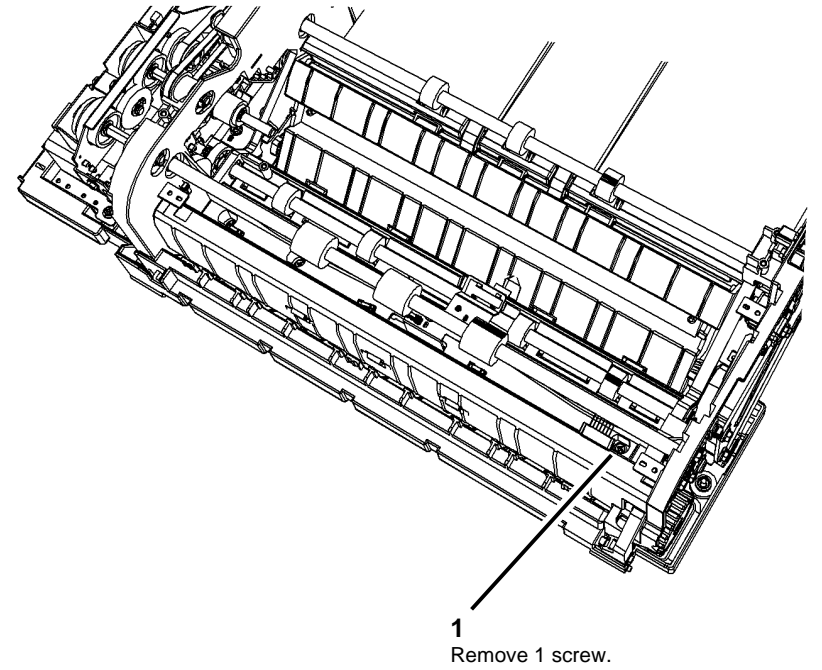
X-1-1-901-A

10. Release the inner fixings, [Figure 6](#).

Figure 6 Inner fixings release.

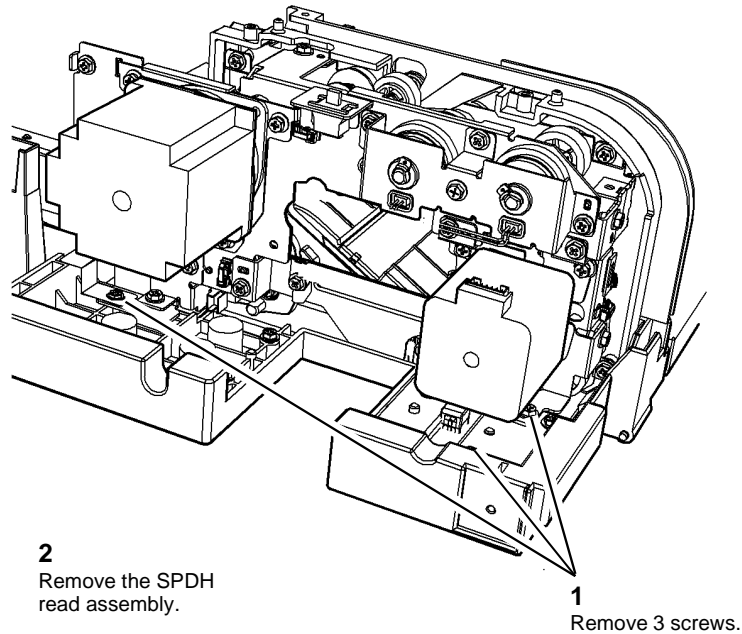
11. Remove the SPDH read assembly, [Figure 7](#).

2
Remove the SPDH
read assembly.

1
Remove 3 screws.

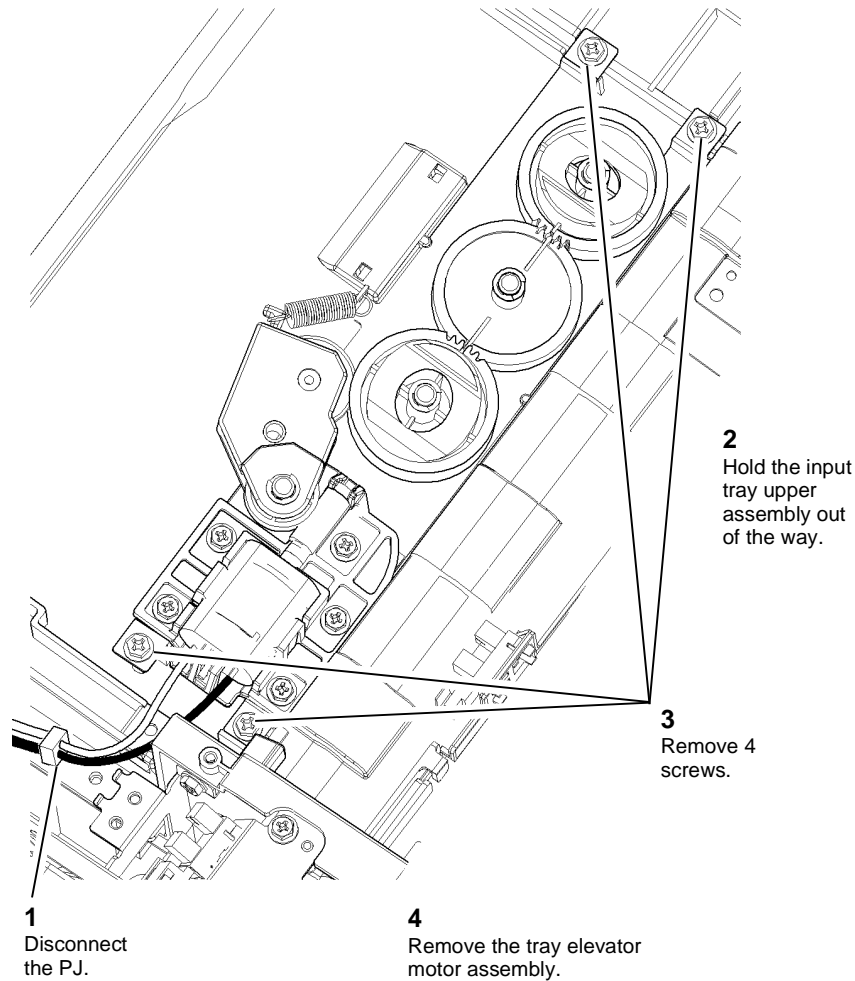
X-1-1875-A

- Remove the tray elevator motor assembly, [Figure 1](#).

Figure 1 Motor assembly removal

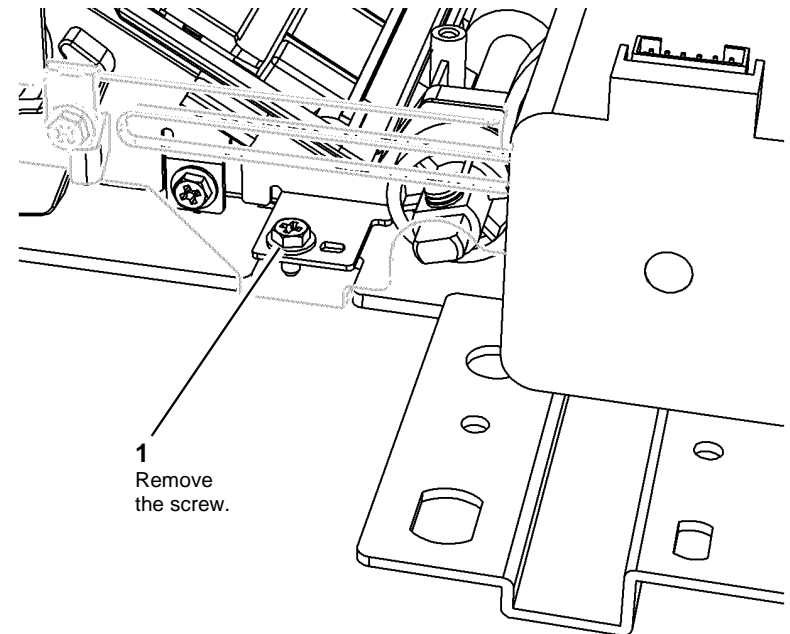
X-1-1903-A

- Remove the read assembly, [REP 5.20](#).
- Remove the feed clutch and read clutch, [REP 5.14](#).
- Prepare to remove the read motor support bracket and read motor, [Figure 2](#).

Figure 1 Preparation

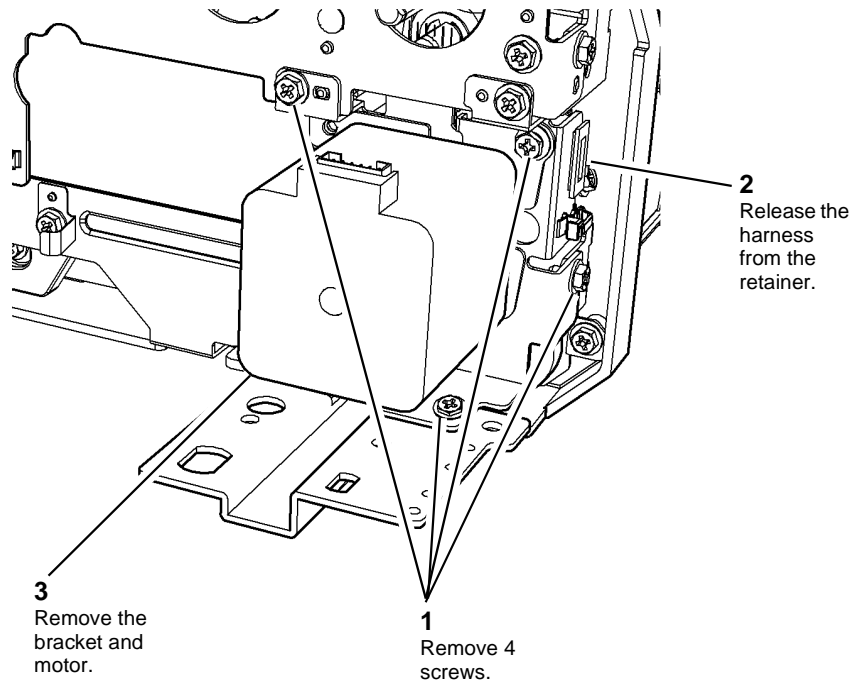
X-1-1904-A

- Remove the read motor support bracket and read motor, [Figure 3](#).

Figure 2 Read motor and bracket

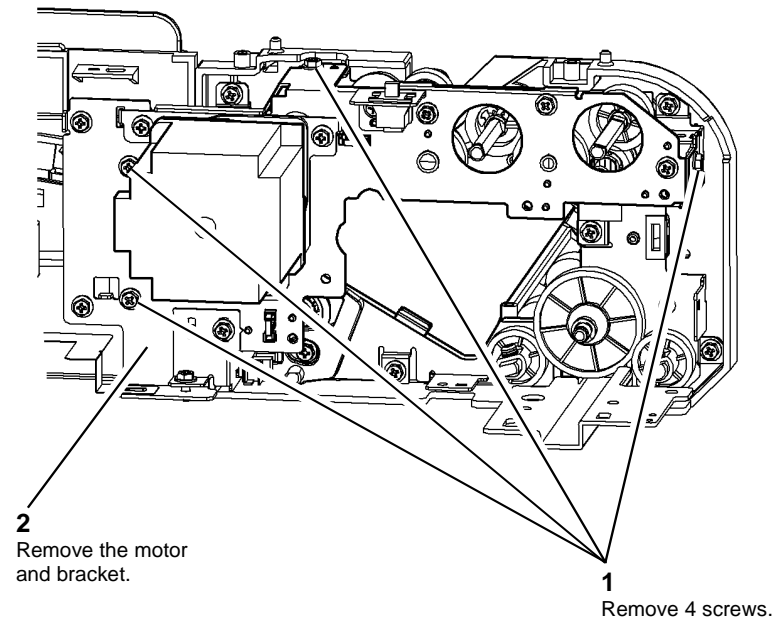
X-1-1905-A

When removing the feed motor and bracket, take care not to damage the calibration home position sensor.

- Remove the feed motor and support bracket, [Figure 3](#).

Figure 3 Feed motor and bracket

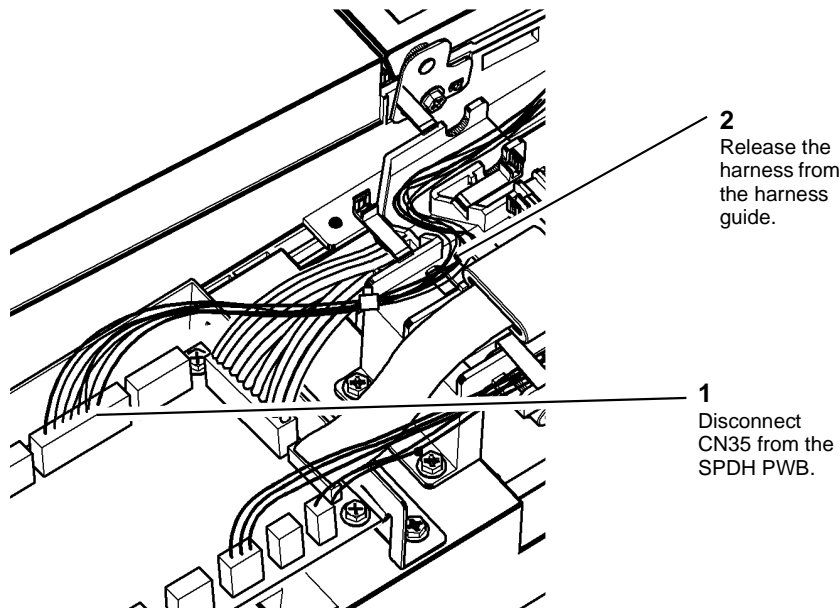
X-1-1906-A

1. Remove 5 screws then remove the SPDH rear cover, [PL 5.10 Item 1](#).
2. Remove 4 screws then remove the SPDH front cover, [PL 5.10 Item 17](#).
3. Prepare to remove the input tray assembly, [Figure 1](#).

Figure 1 Preparation

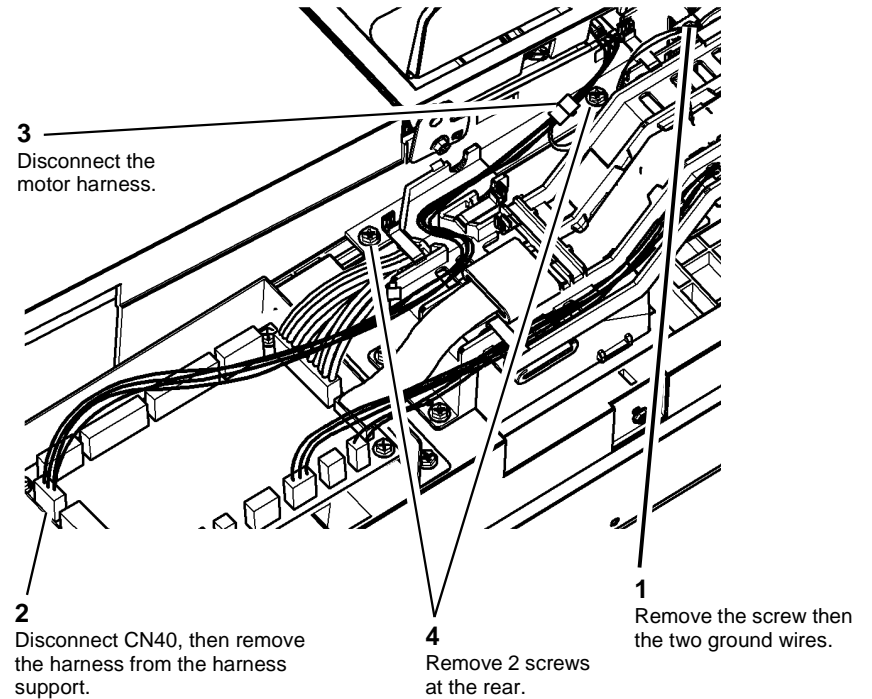
X-1-1907-A

4. Prepare to remove the input tray assembly, [Figure 2](#).

Figure 2 Preparation

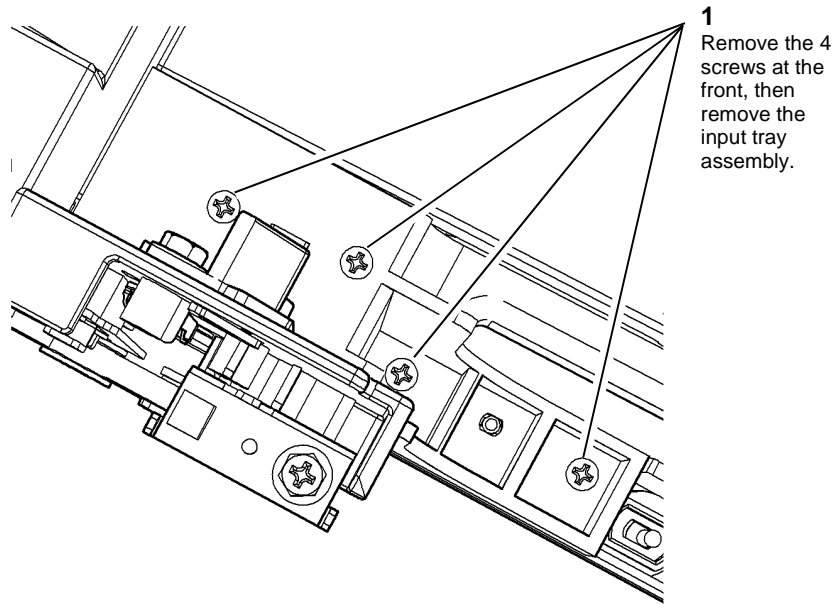
X-1-1908-A

5. Remove the input tray assembly, [Figure 3](#).

Figure 3 Input tray removal

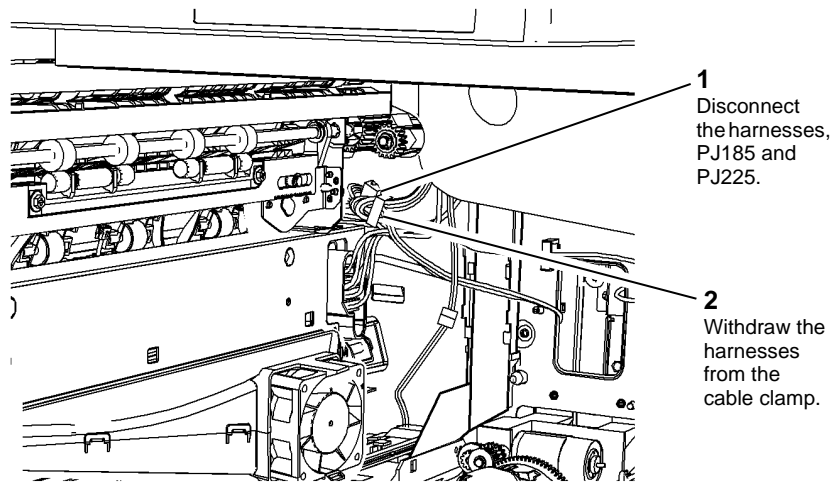
X-1-1149-A

1. Open the front door.
2. Open the left door.
3. Remove the print cartridge, [PL 90.17 Item 9](#), then place in a black bag.
4. Remove the horizontal transport, [REP 10.6](#).
5. Disconnect the harnesses to the inverter, [Figure 1](#).

Figure 1 Harness disconnection
