708P91368
September 2017

Xerox® AltaLink® B8090 Family Multifunction Printer Service Manual

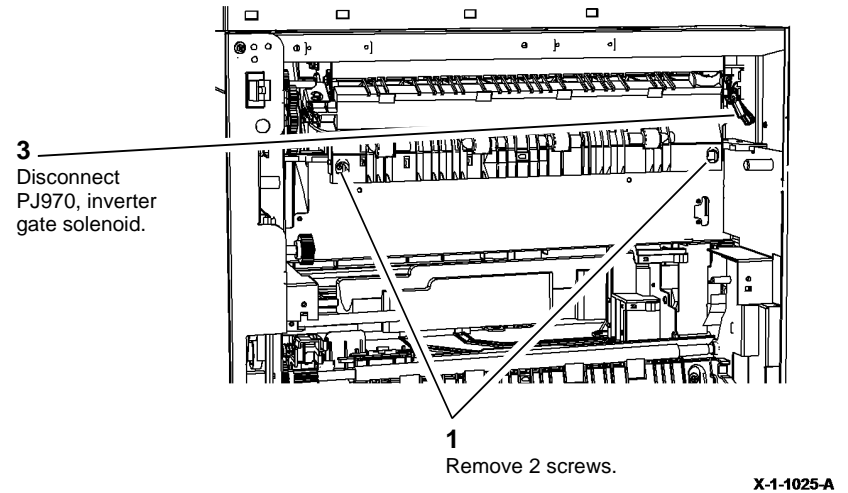
X-1-1025-A

6. Prepare to remove the inverter assembly, [Figure 2](#).

Figure 2 Inverter removal preparation

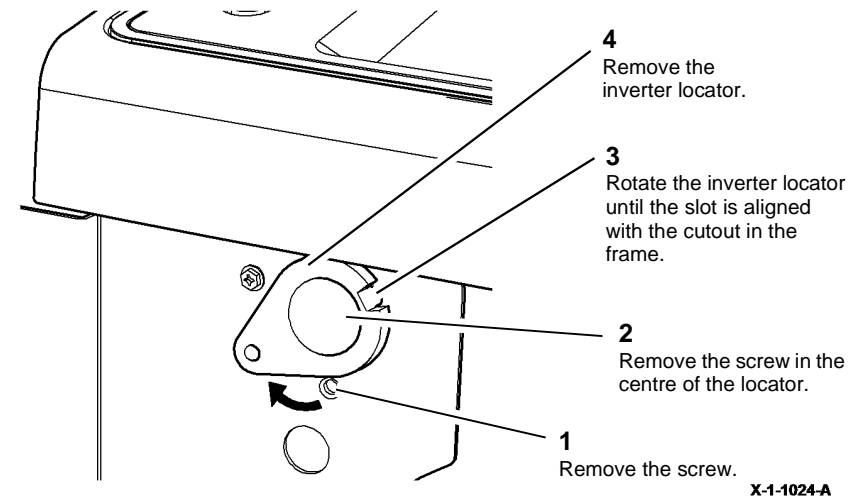
X-1-1024-A

7. Remove the exit drive assembly, [REP 10.2](#).
8. Remove the inverter locator, [Figure 3](#).

Figure 3 Inverter locator removal

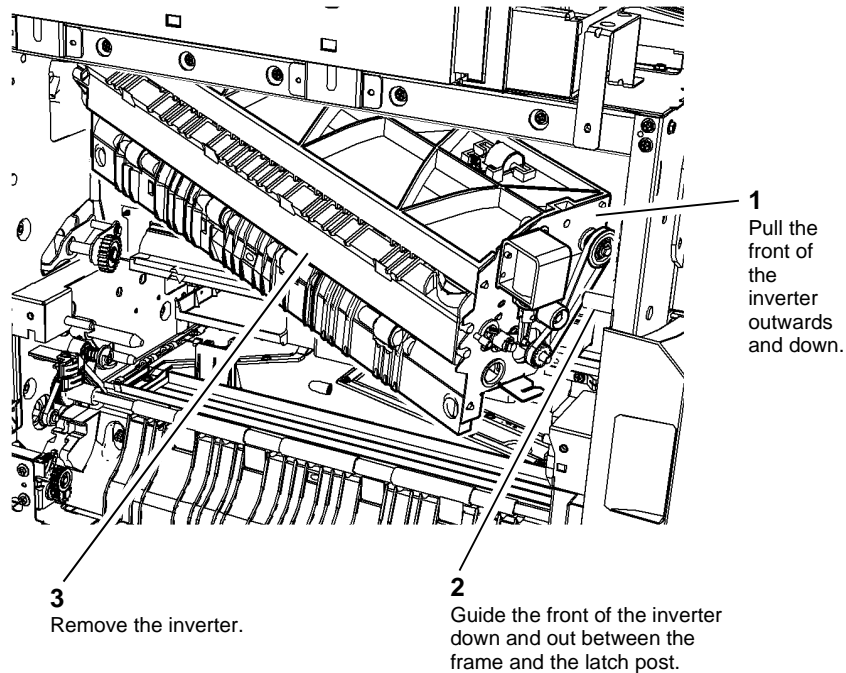
- Remove the inverter assembly, [Figure 4](#).

Figure 4 Inverter removal

Screws must be replaced in the exact reverse of the removal order shown to ensure the optimum alignment of the inverter assembly.

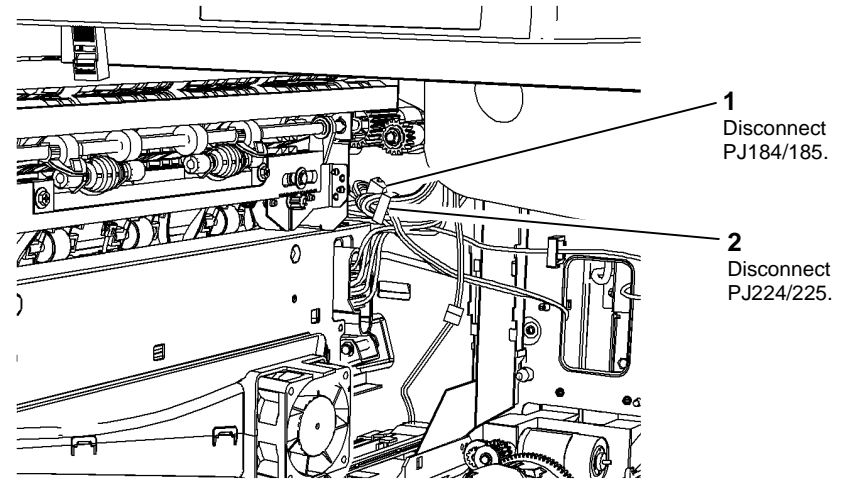
X-1-1027-A

- Disconnect the harnesses to the inverter, [Figure 1](#).

Figure 5 Harness disconnection

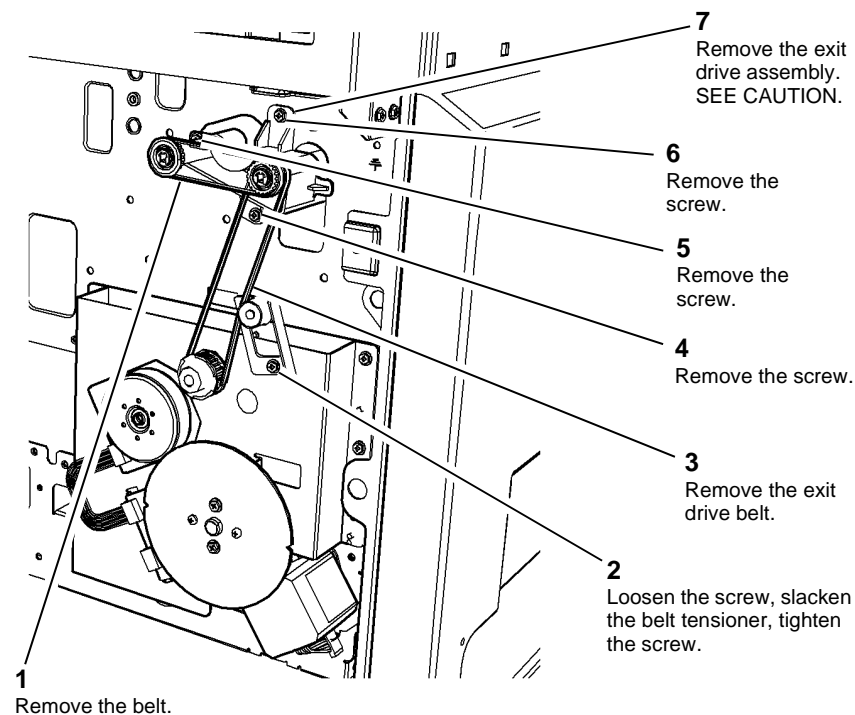
X-1-1028-A

2. Remove the exit drive assembly, [Figure 1](#).

Figure 1 Exit drive assembly removal

Screws must be replaced in the exact reverse of the removal order shown to ensure the optimum alignment of the exit drive assembly.

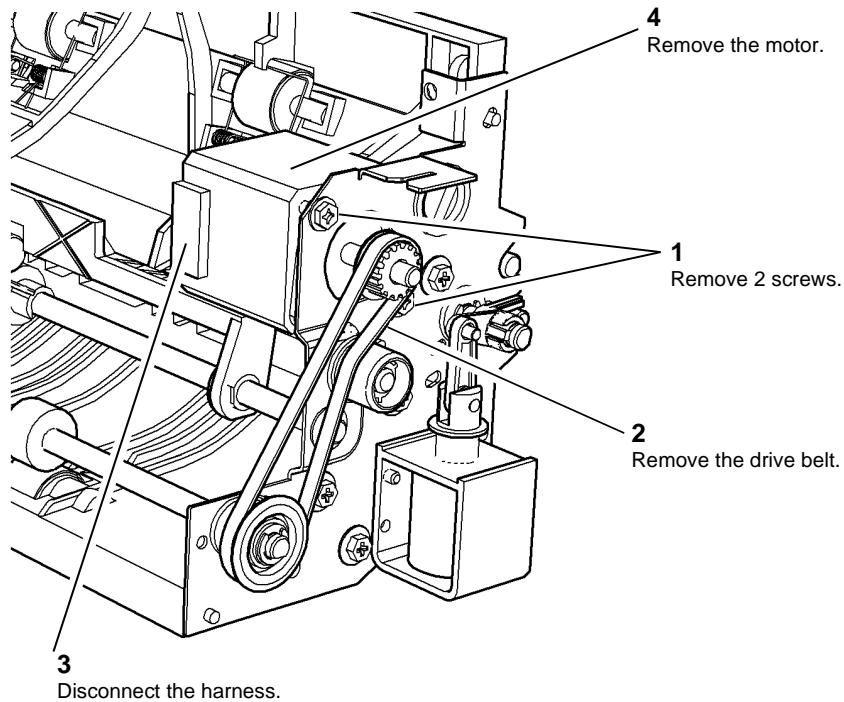
X-1-1030-A

1. Remove the inverter assembly, [REP 10.1](#).
2. Remove the inverter motor, [Figure 1](#).

Figure 1 Inverter motor removal

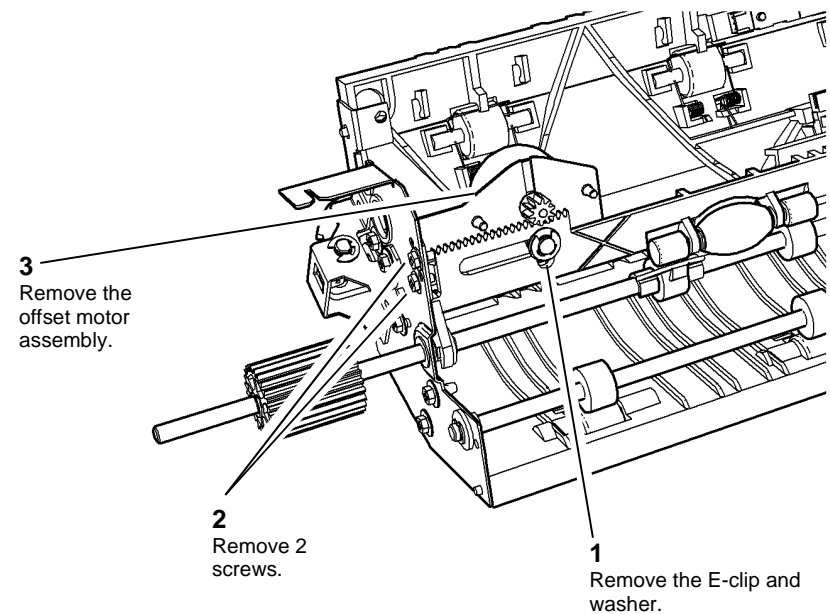
X-1-1031-A

1. Remove the inverter assembly, [REP 10.1](#).
2. Remove the offset motor assembly, [Figure 1](#).

Figure 1 Offset motor removal

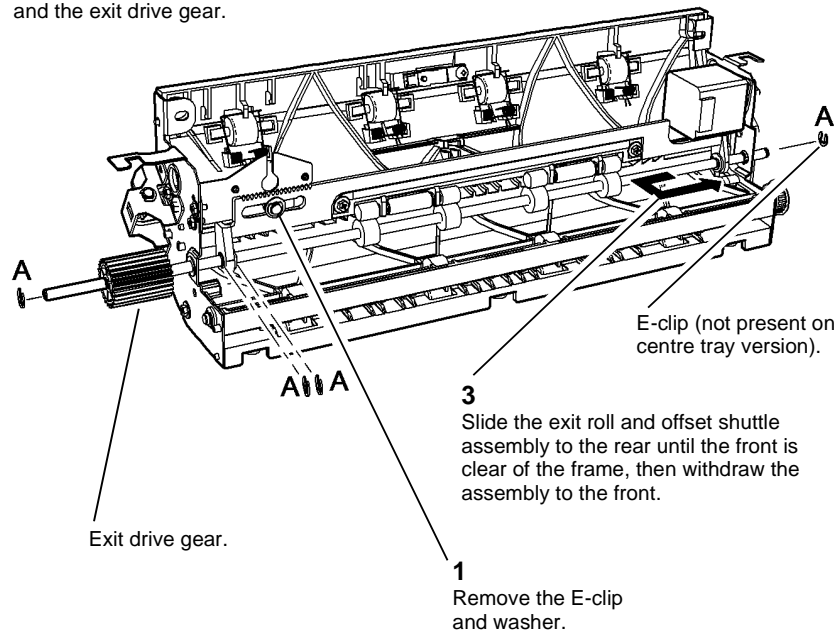
Remove 3 E-clips (centre tray) or 4 E-clips (horizontal transport) marked A, and the exit drive gear.

Figure 1 Shaft and shuttle removal

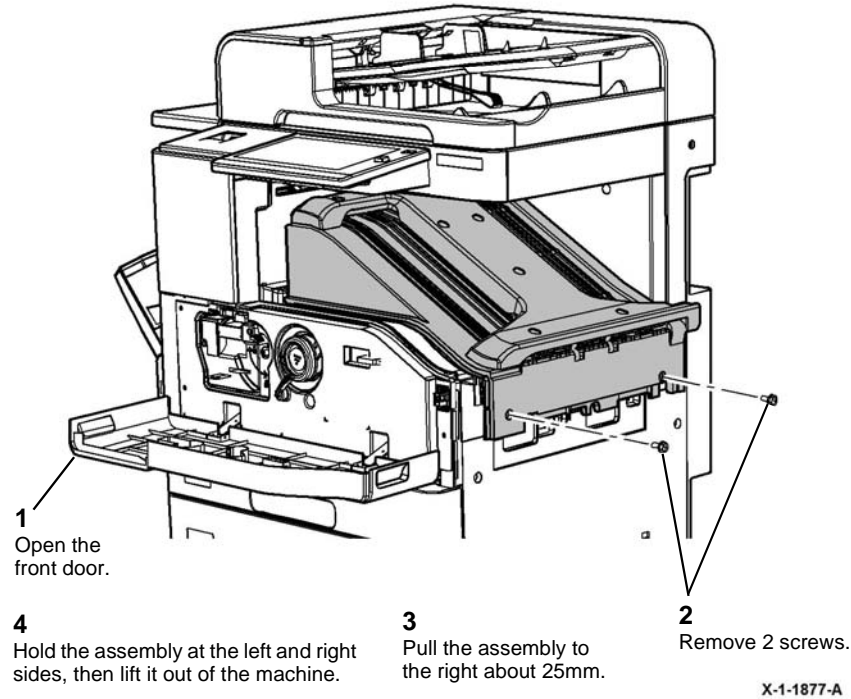
- Remove the horizontal transport assembly, [Figure 1](#).

Figure 1 Removal

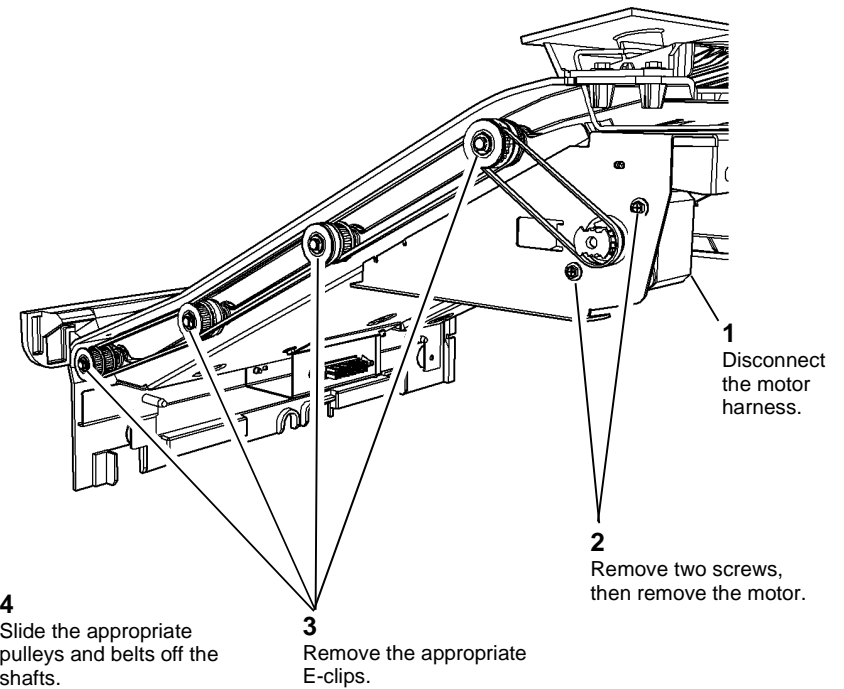
- Remove the horizontal transport assembly, [REP 10.6](#).
- Remove the horizontal transport motor or horizontal transport drive belt, as necessary, [Figure 1](#).

NOTE: If removing only the drive belt, perform steps 2 and 3 only in [Figure 1](#).

Figure 1 Motor or belt removal

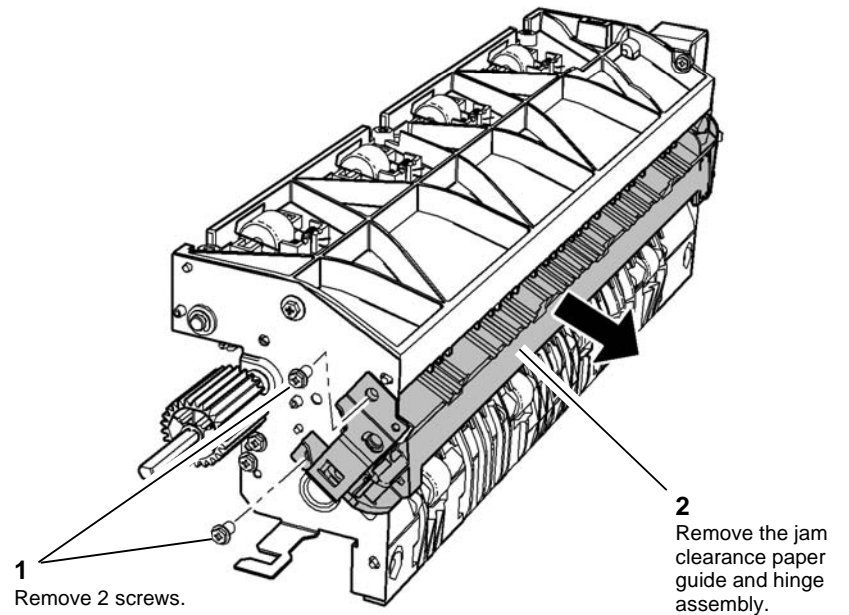
X-1-1452-A

1. Remove the Inverter Assembly, [REP 10.1](#).
2. Remove the jam clearance paper guide & hinge assembly, [Figure 1](#).

Figure 1 Assembly removal

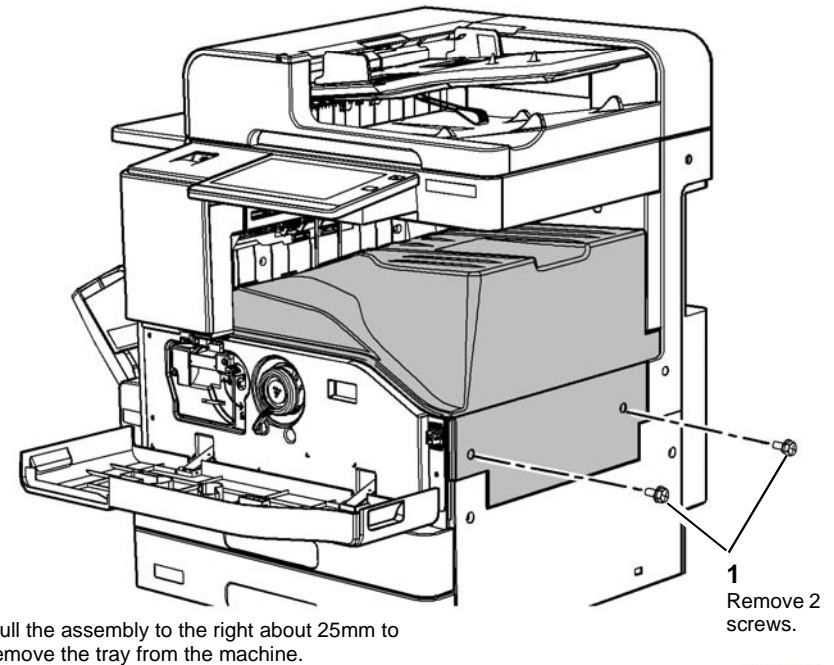
X-1-2012-A

1. Open the front door.
2. Remove the centre output tray, [Figure 1](#).

Figure 1 Removal

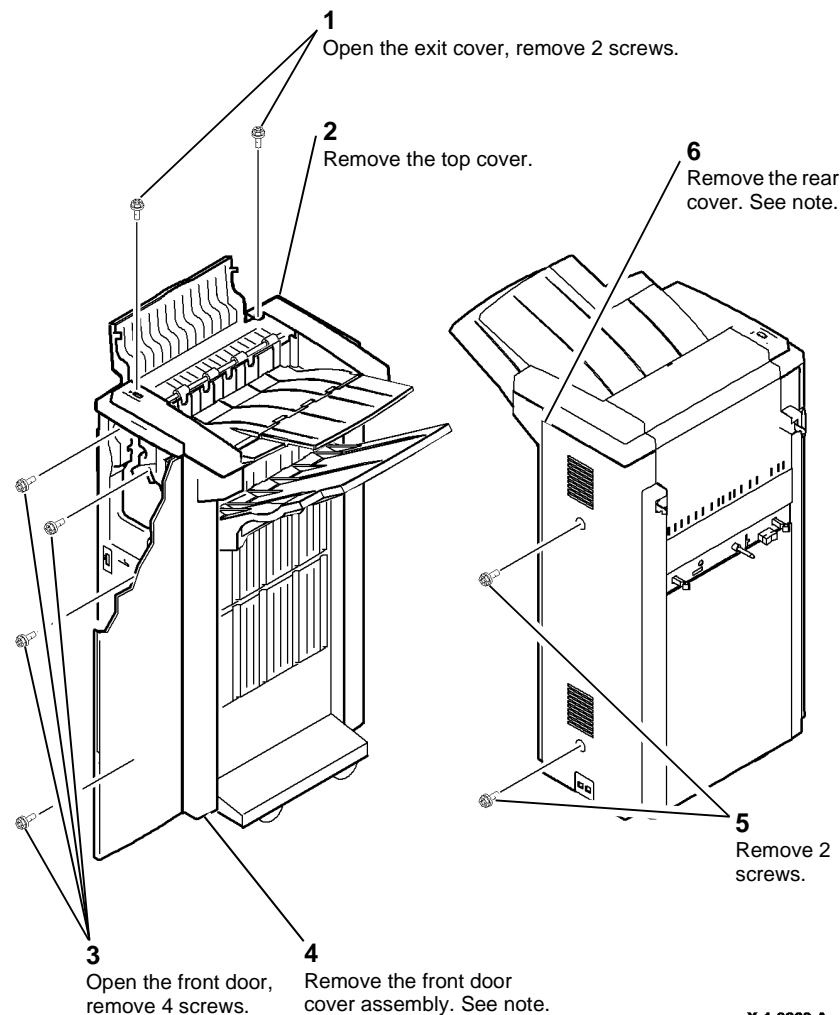
X-1-0263-A

NOTE: Later versions of the 2K LCSS rear cover and front door cover assembly may be additionally retained by protrusions that locate in holes in the frame edges. These protrusions are best released by pulling on the bottom section of the covers.

Remove the covers, [Figure 1](#).

Figure 1 Covers removal

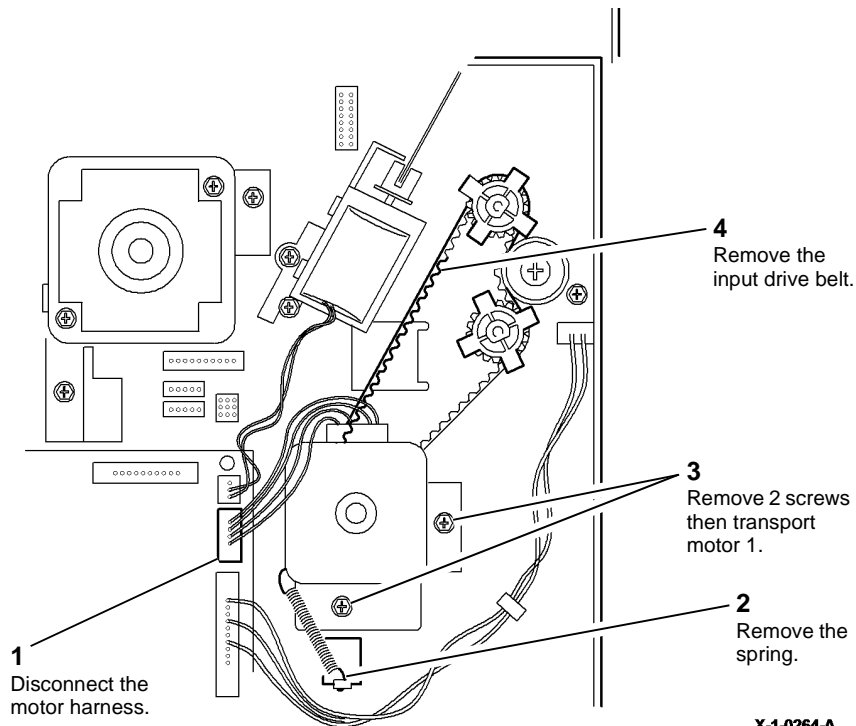
1. Place the input drive belt around the pulleys.
2. Install the motor screws, but do not tighten.
3. Install the spring
4. Rotate the shaft by hand to ensure the belt runs smoothly over the pulleys and allows the spring to tension the belt, [ADJ 12.3-110](#).
5. Tighten the motor screws and re-connect the harness.
6. Install the 2K LCSS top cover and rear cover, [REP 12.1-110](#).

Figure 1 Component removal

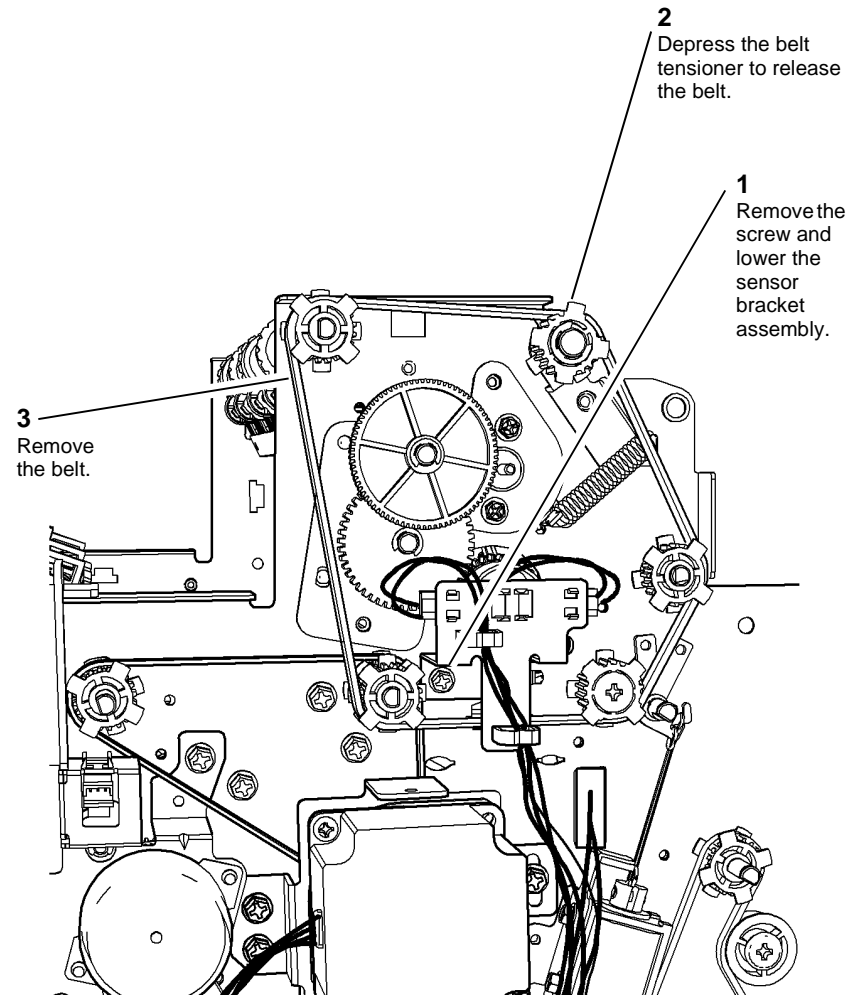
X-1-0265-A

1. Remove the 2K LCSS top cover and rear cover, [REP 12.1-110](#).
2. Remove the intermediate paper drive belt, [Figure 1](#).

Figure 1 Belt removal

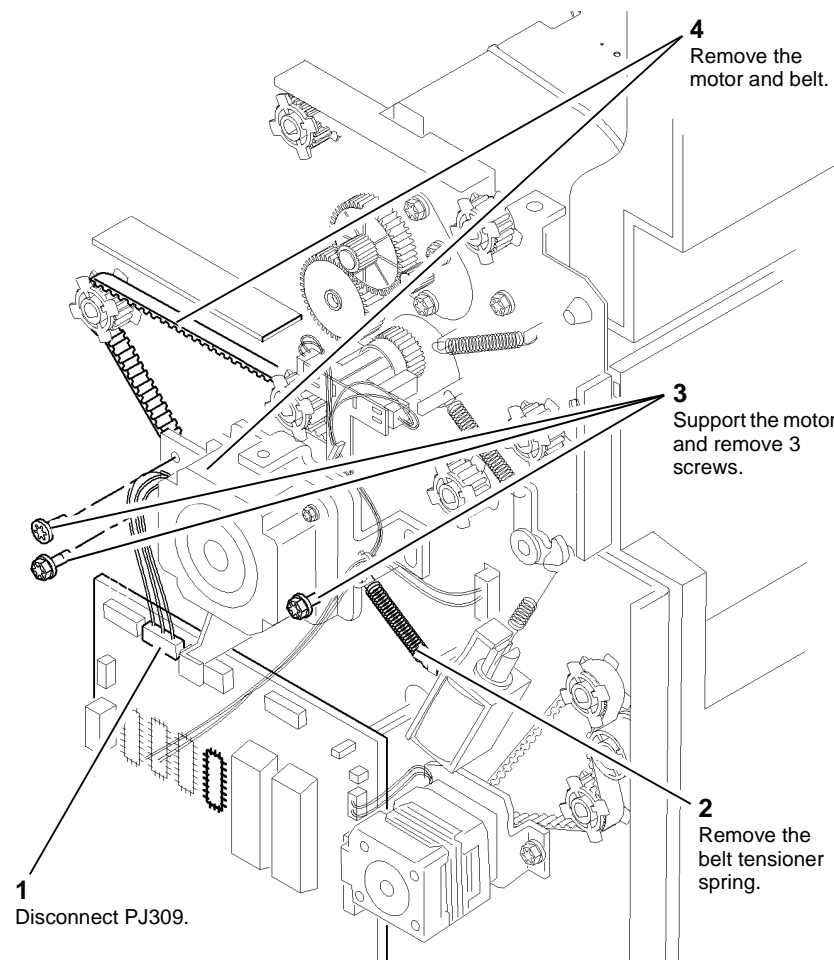
1. Remove the 2K LCSS top cover and rear cover, [REP 12.1-110](#).
2. Remove the intermediate paper drive belt, [REP 12.3-110](#).
3. Remove the paper output drive belt and transport motor 2, [Figure 1](#).

Figure 1 Component removal

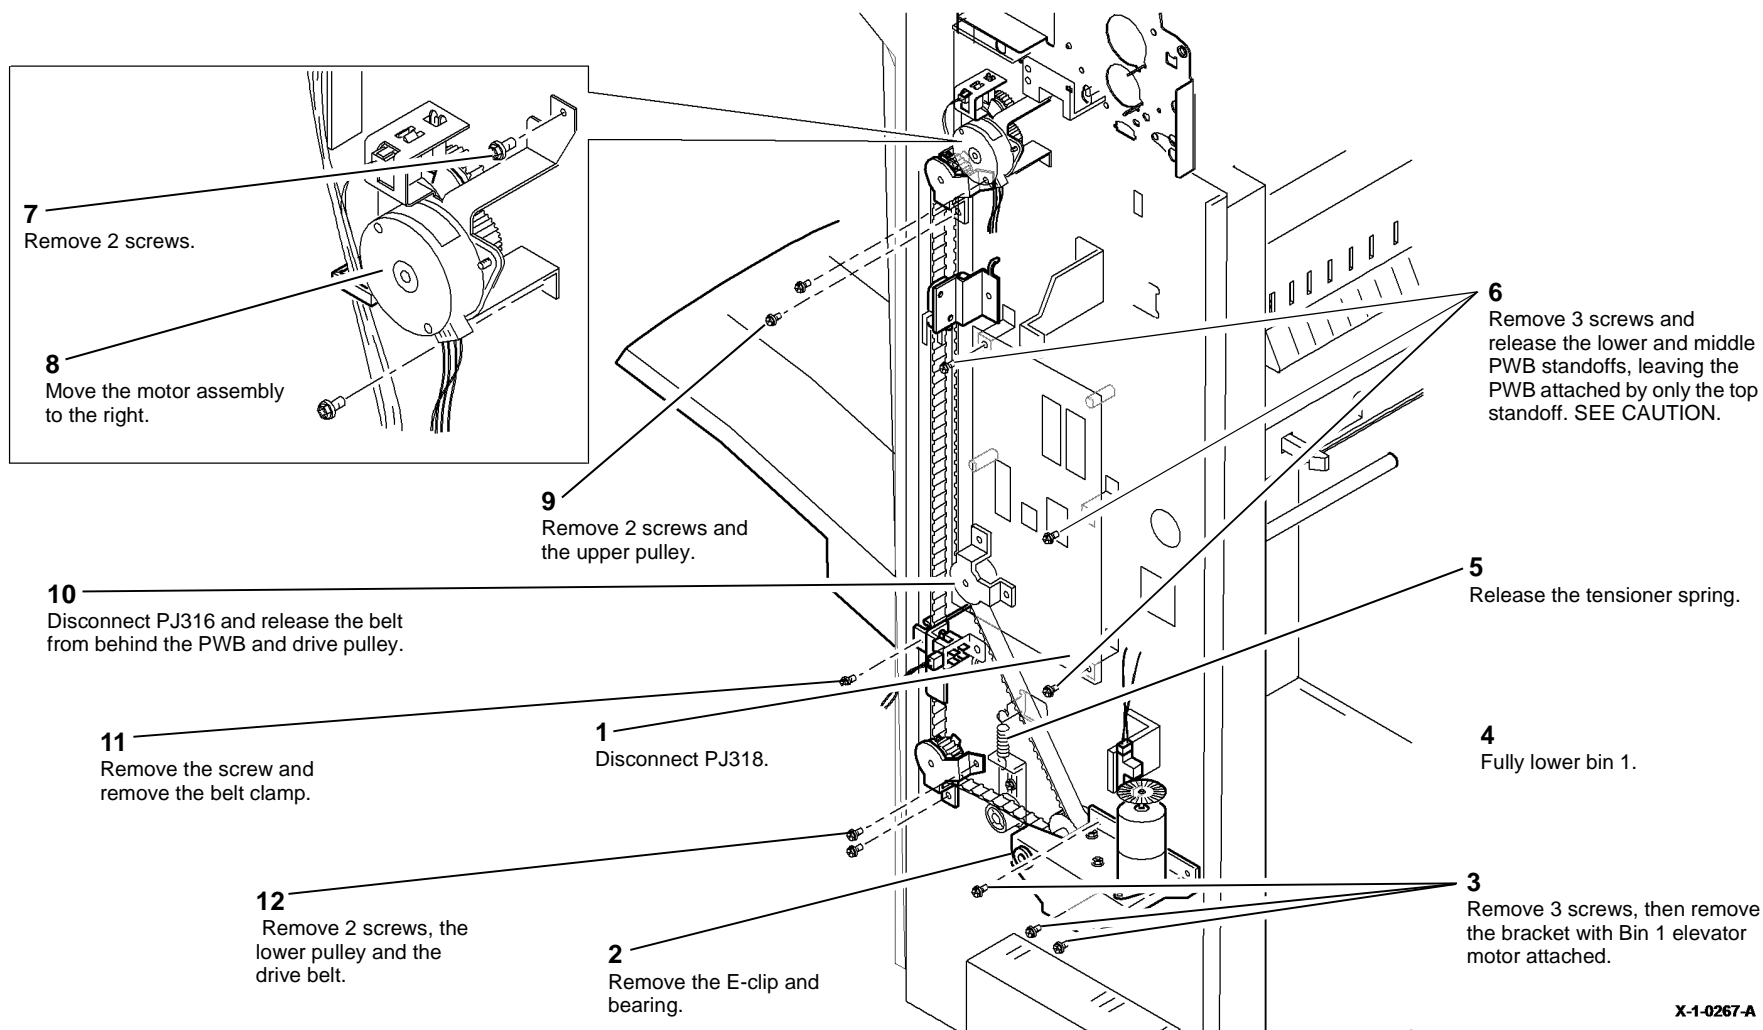
X-1-0267-A

2. Remove the bin 1 drive belt (rear) [Figure 1](#).

Figure 1 Rear belt removal

Ensure that ESD procedures are observed during step 6 of [Figure 1](#).

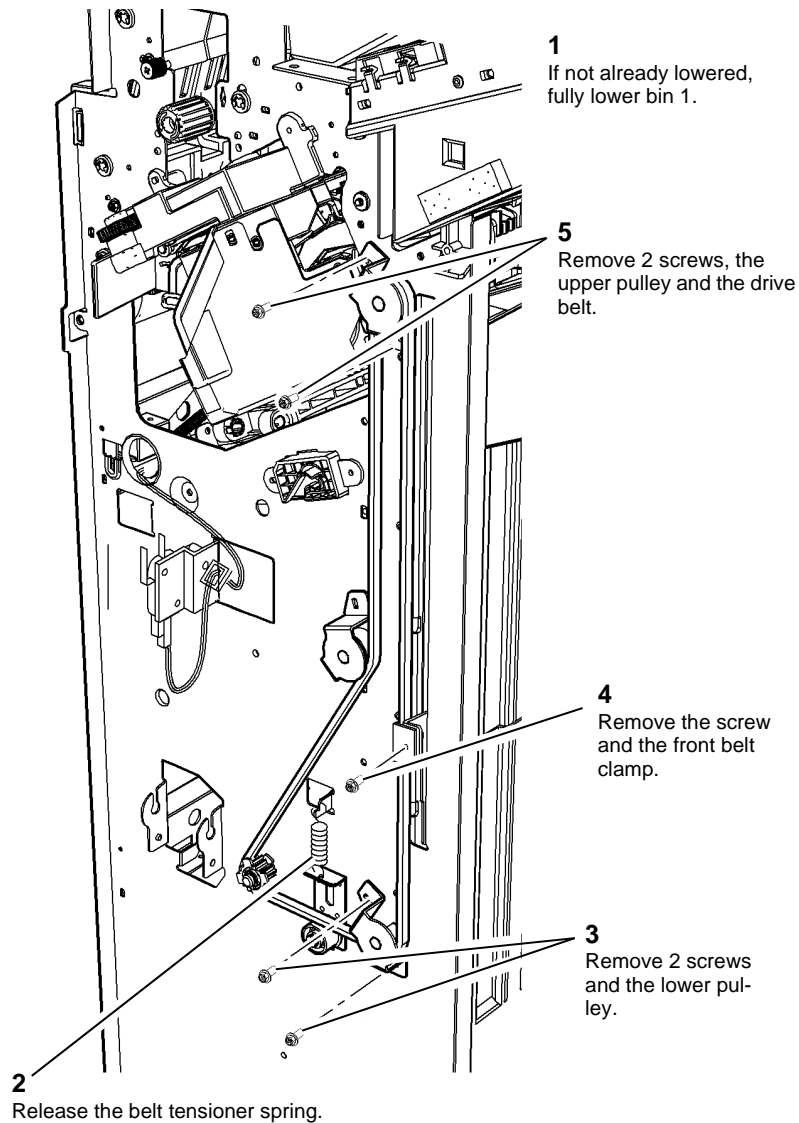
Keep all of the front components as a set. The set of components on the front are different from the rear components.

3. Remove the bin 1 drive belt (front) [Figure 2](#).

Figure 2 Front belt removal

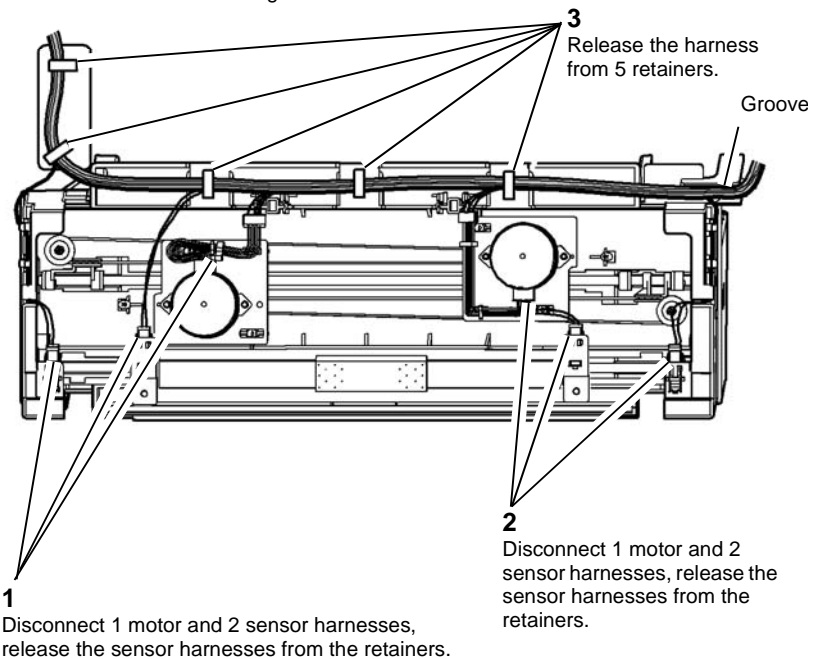
X-1-0269-A

Release the harness from the groove.

Figure 1 Preparation

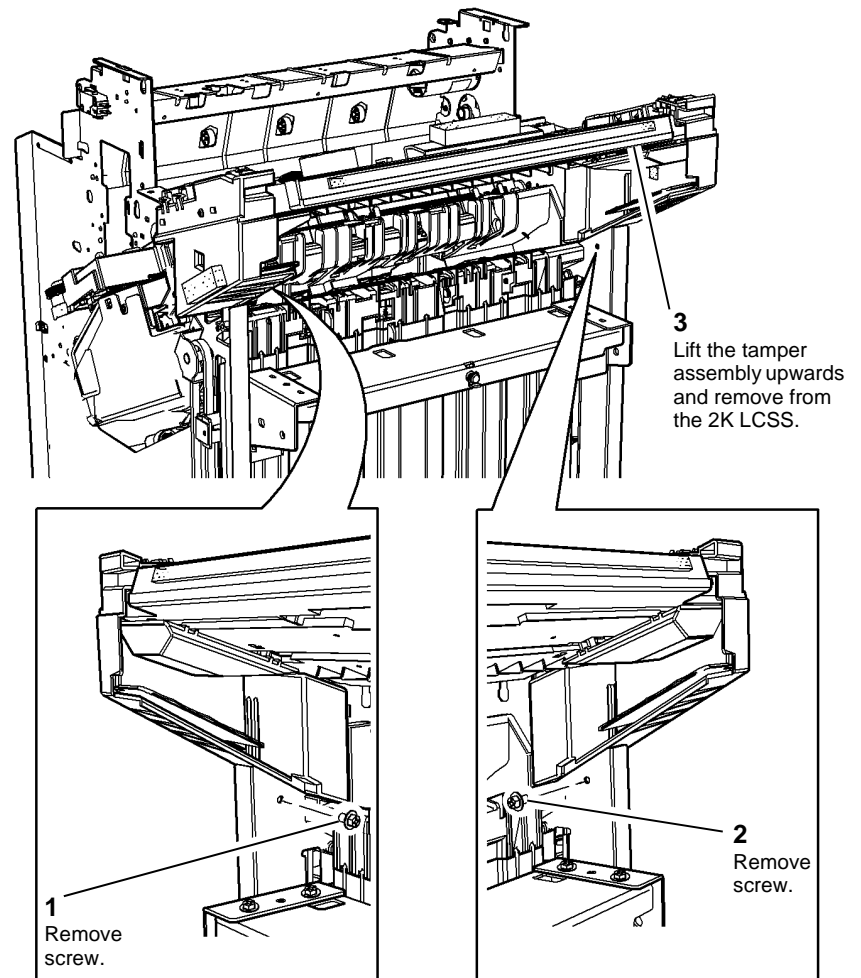
X-1-0270-A

3. Remove the tamper assembly, [Figure 2](#).

NOTE: For clarity, bin 1, [PL 12.10 Item 10](#) has been omitted from [Figure 2](#).

Figure 2 Tamper assembly removal

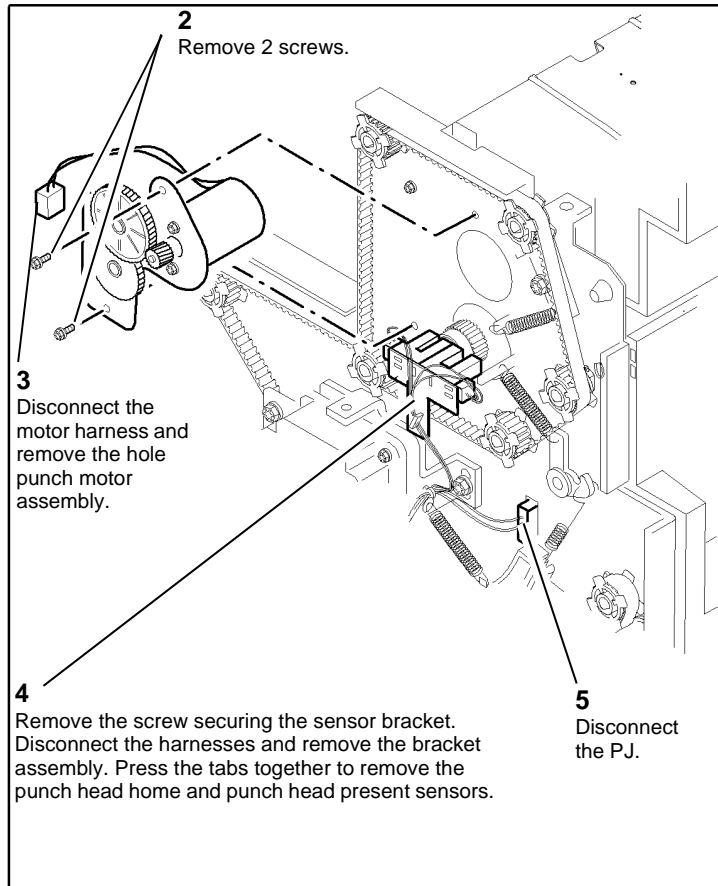
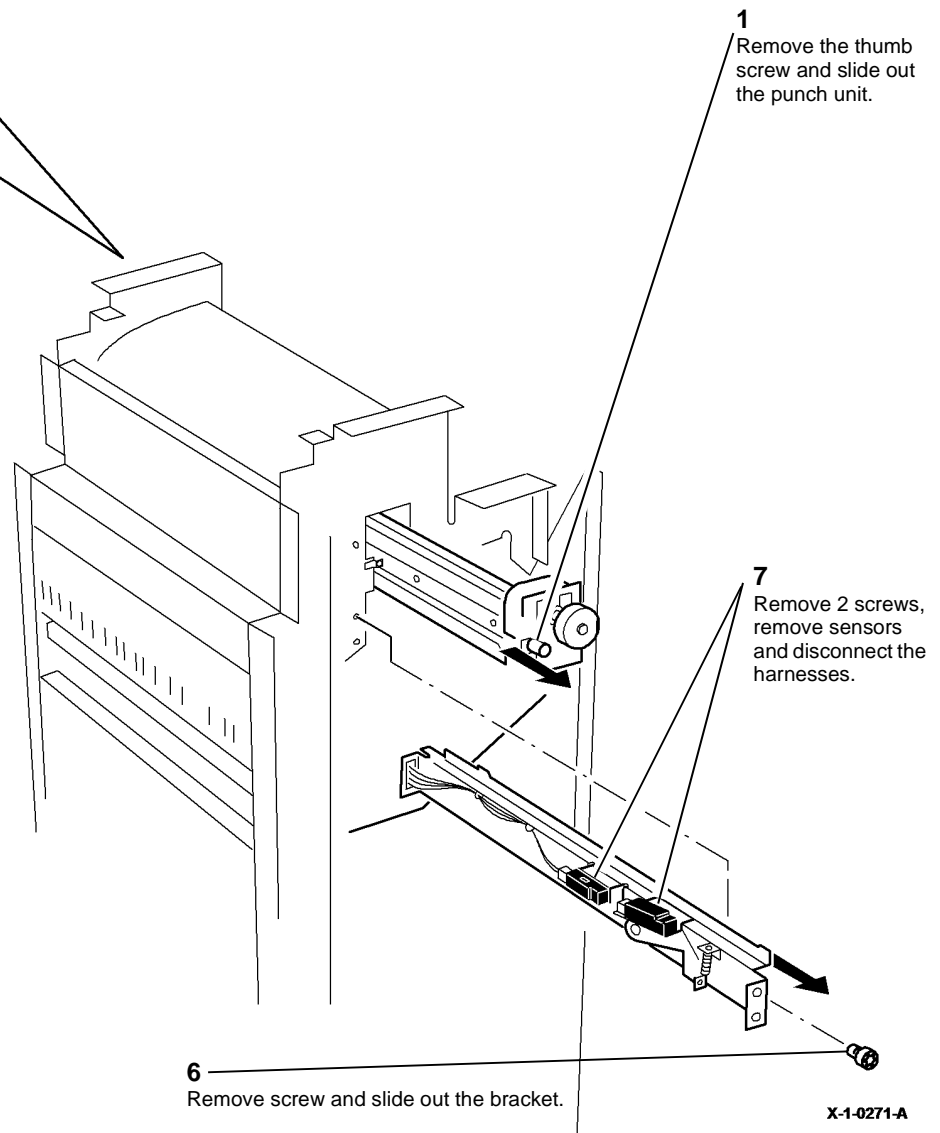
1. Remove the 2K LCSS covers, [REP 12.1-110](#).
2. Remove and empty the chad bin, [PL 12.20 Item 4](#).
3. Remove the hole punch unit, motor assembly and sensors, [Figure 1](#).

Figure 1 Component removal

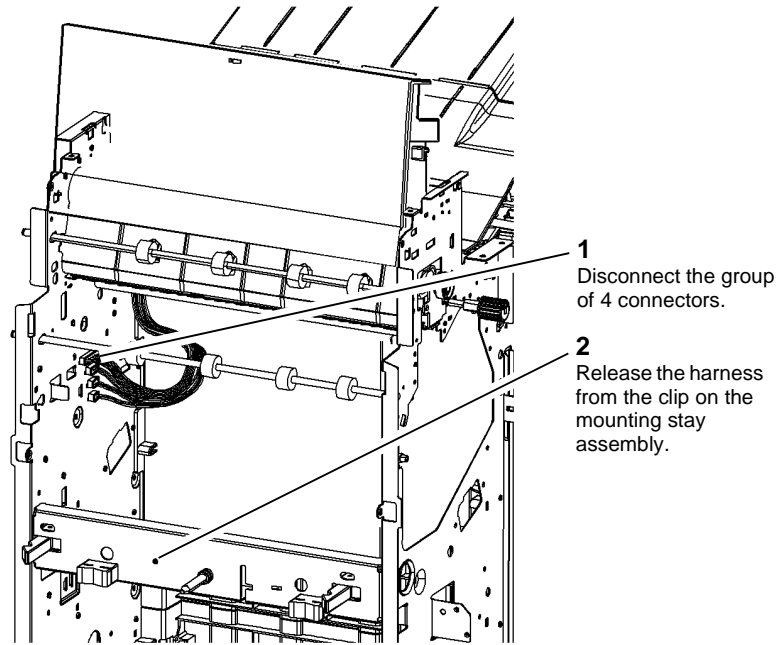
X-1-0272-A

5. Disconnect the harness, [Figure 1](#).

Figure 1 Harness disconnection

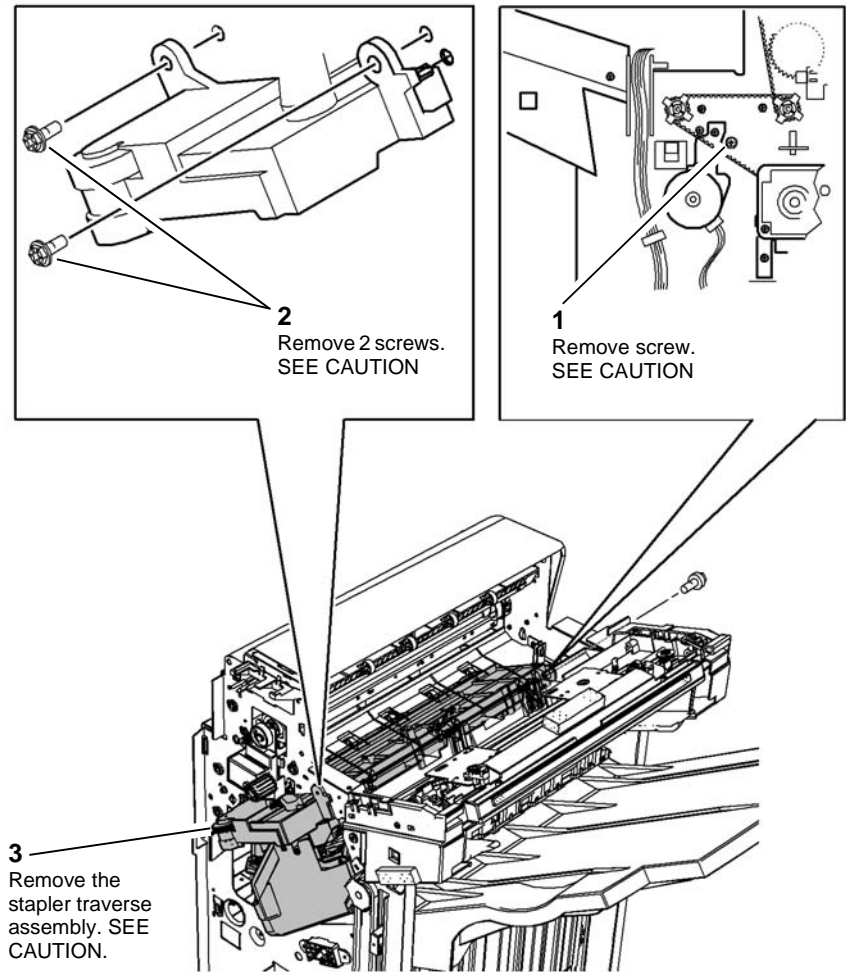
X-1-0273-A

When removing and replacing the stapler traverse assembly, support the weight of the assembly underneath the stapler and take care not to damage the wiring.

6. Remove the stapler traverse assembly, [Figure 2](#).

Figure 2 Traverse assembly removal

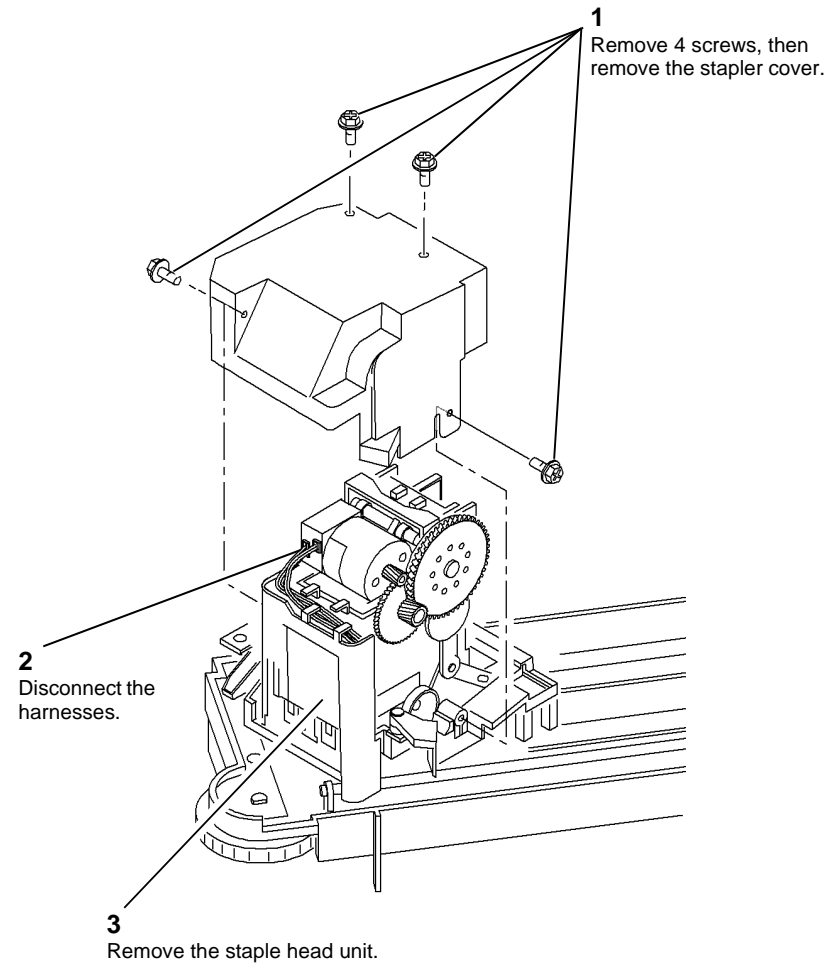
X-1-0274-A

3. Remove the staple head unit from the stapler traverse assembly [Figure 1](#).

Figure 1 Staple head unit removal

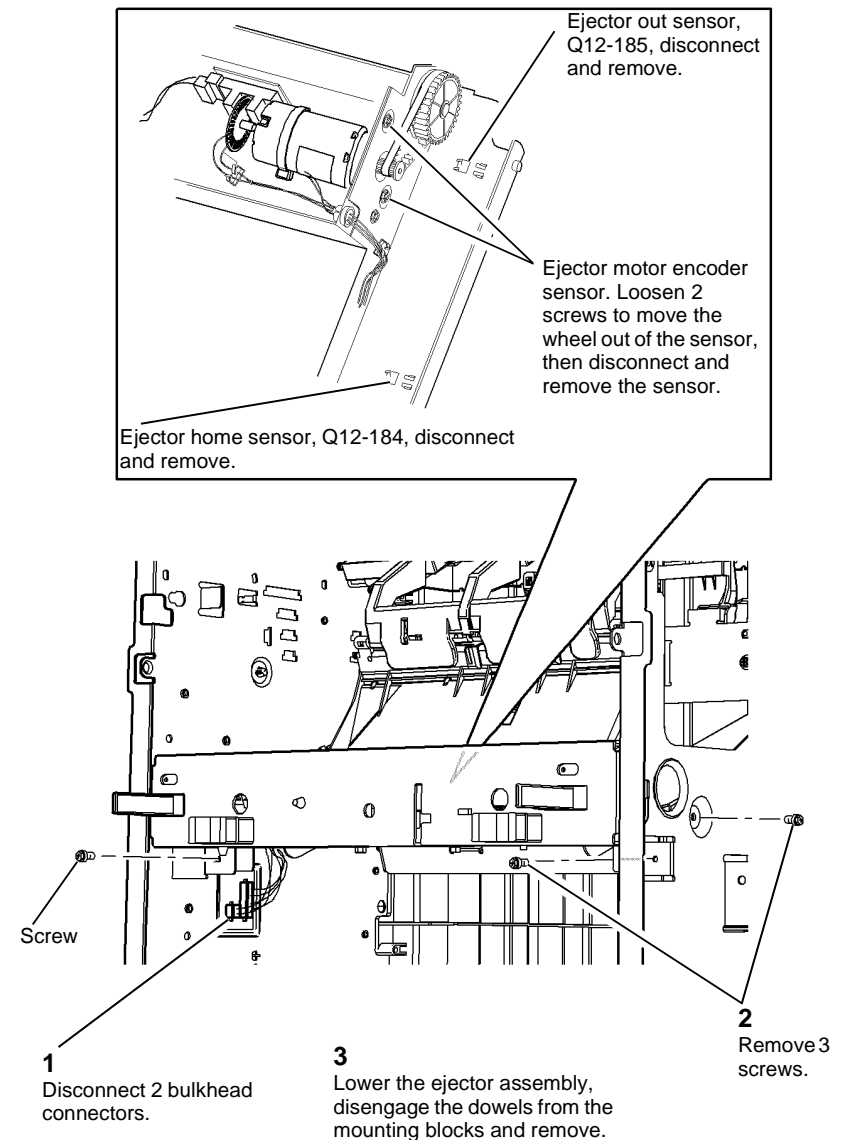
X-1-0275-A

NOTE: The home position of the stapling unit is when the staple head unit is at the corner stapling position (fully to the front of the 2K LCSS and rotated through 45 degrees).

1. Disconnect the 2 harnesses between the 2K LCSS and the machine.
2. Un-dock the 2K LCSS, REP 12.13-110 and move it away from the machine.
3. Remove the top cover and front door cover assembly, REP 12.1-110.
4. Ensure the stapling unit is at the home position.
5. If necessary, manually move the ejector to the home (left) position.
6. Figure 1, remove the ejector assembly.

Figure 1 Ejector assembly removal

When installing the ejector assembly onto the 2K LCSS, ensure that the ejector fingers do not damage the wiring to the staple head unit.

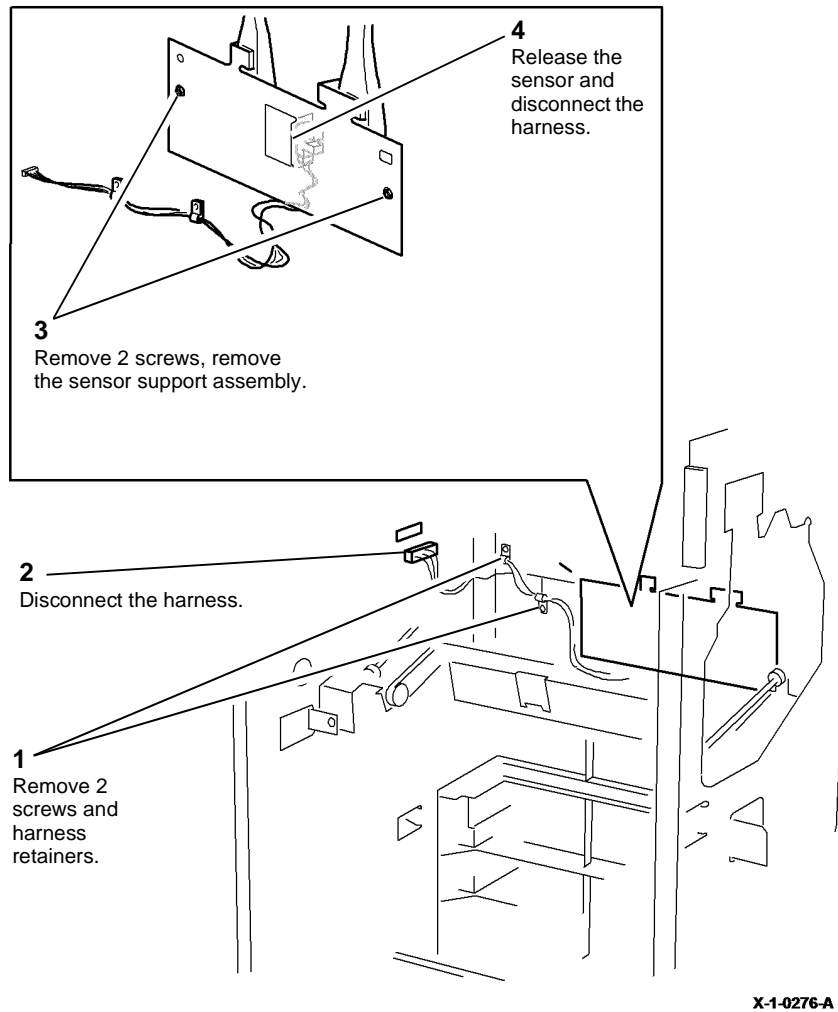
2. Remove the bin 1 upper level sensor, [Figure 1](#).

Figure 1 Removal

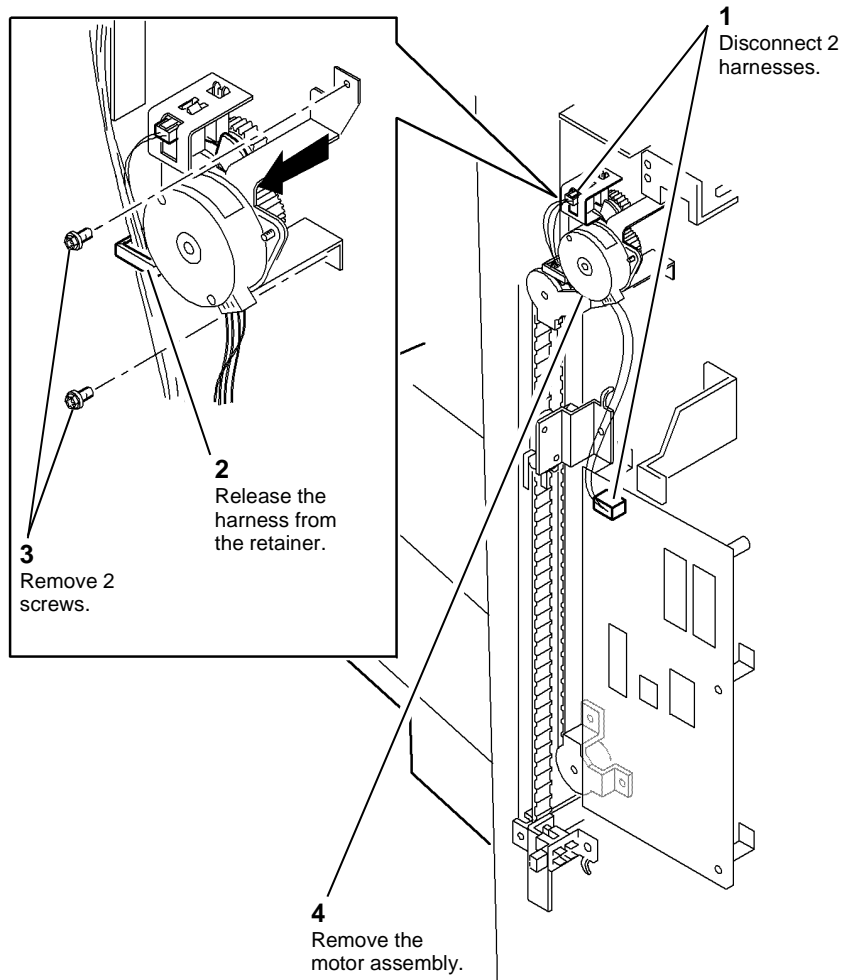
X-1-0277-A

3. Remove the paddle motor assembly, **Figure 1**.

Figure 1 Paddle motor removal

1. Install the paddle shaft assembly, front bearing and E-clip. Refer to [Figure 3](#).
2. Install the output cover. Refer to [Figure 4](#).
3. Install the rear bearing and E-clip. Refer to [Figure 2](#).
4. Install the gear and flag assembly, with the E-clip.
5. Install the paddle motor assembly. Refer to [Figure 1](#).
6. Ensure the paddles and flag are correctly aligned, [Figure 5](#).

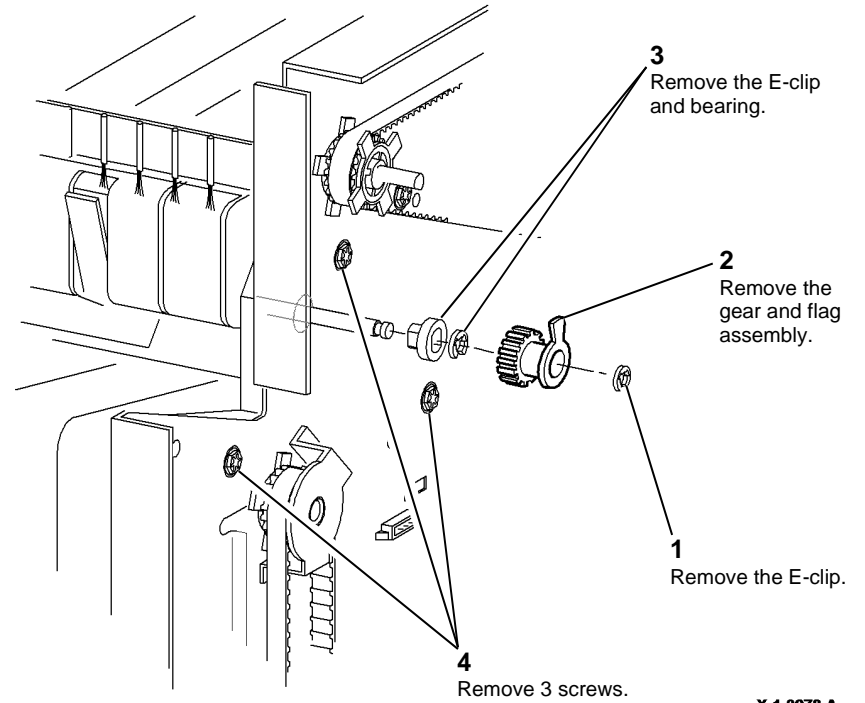
X-1-0278-A

4. Prepare to remove the rear components, **Figure 2**.

Figure 2 Rear preparation

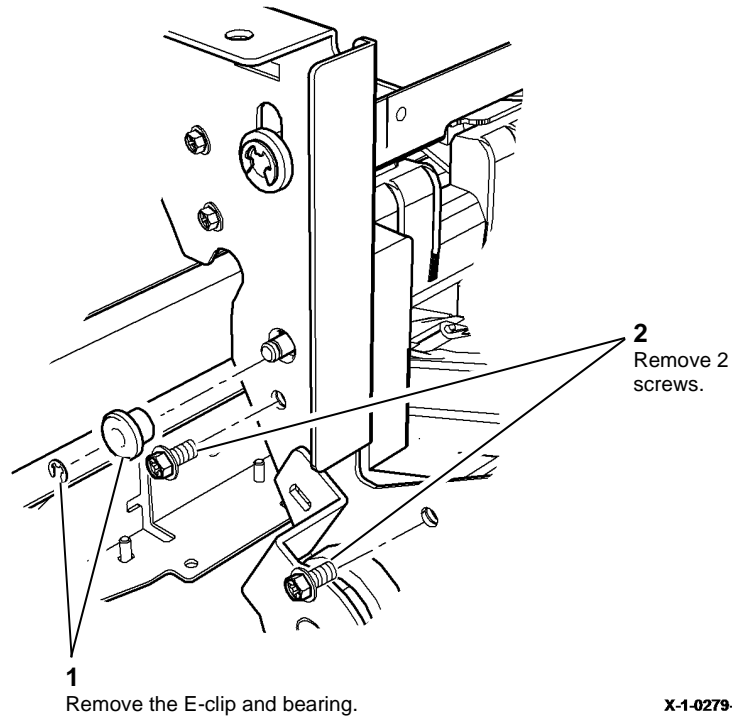
5. Prepare to remove the front components, [Figure 3](#).

Figure 3 Front preparation
