708P91368
September 2017

Xerox® AltaLink® B8090 Family Multifunction Printer Service Manual

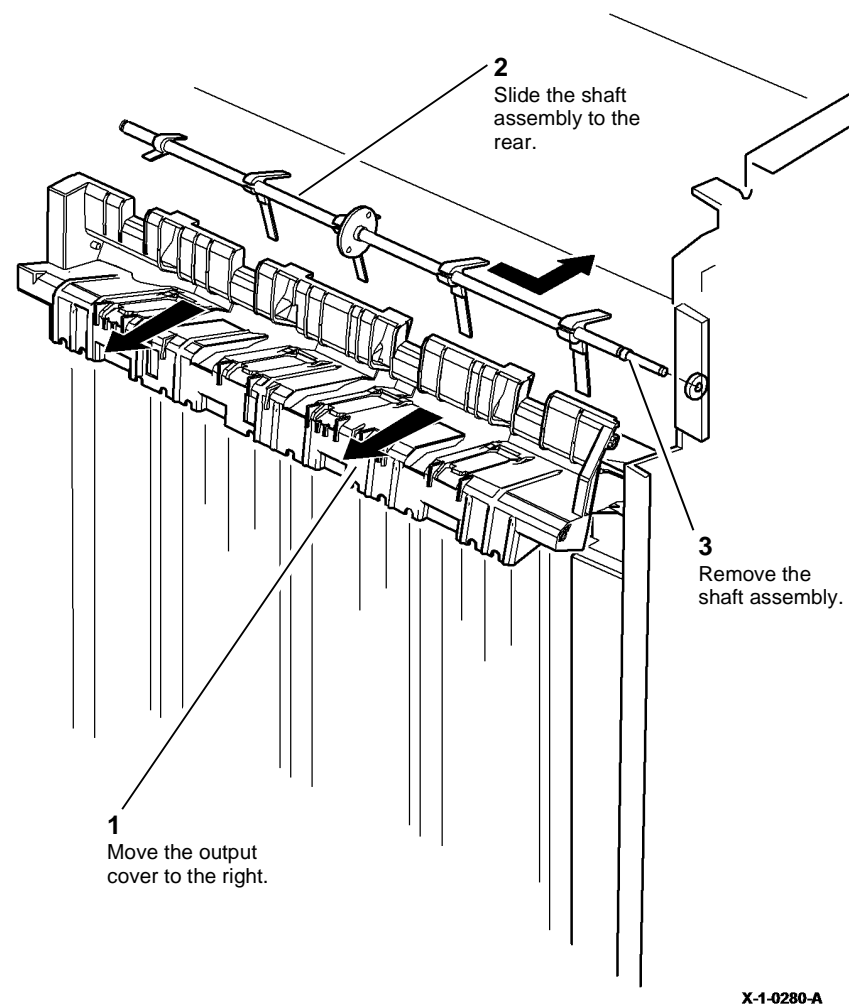
7. Remove the paddle shaft assembly, [Figure 4](#).

Figure 4 Paddle shaft removal

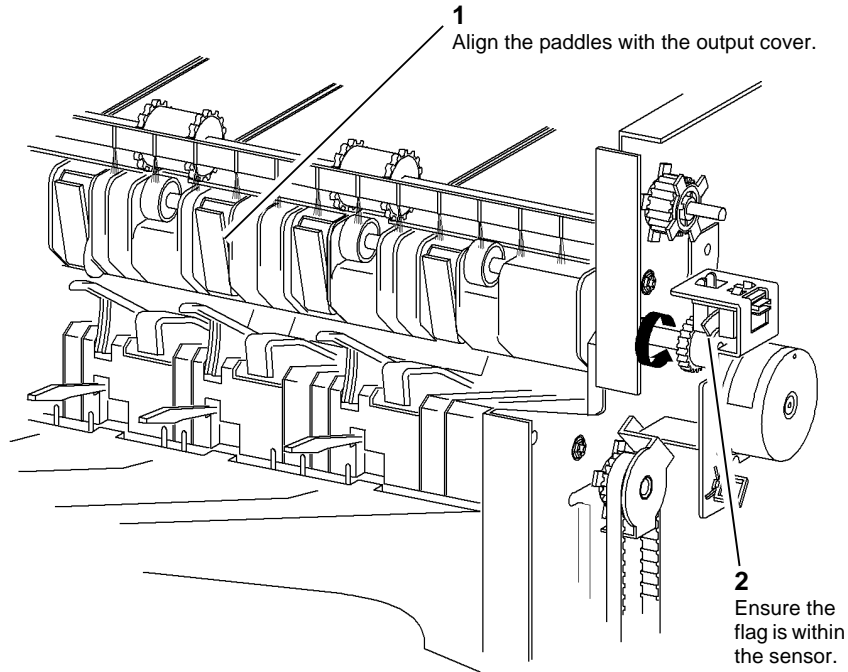
X-1-0281-A

1. Install the paddle shaft assembly, front bearing and E-clip. Refer to [Figure 3](#).
2. Install the output cover. Refer to [Figure 4](#).
3. Install the rear bearing and E-clip. Refer to [Figure 2](#).
4. Install the gear and flag assembly, with the E-clip.
5. Install the paddle motor assembly. Refer to [Figure 1](#).
6. Ensure the paddles and flag are correctly aligned, [Figure 5](#).

Figure 5 Paddle alignment

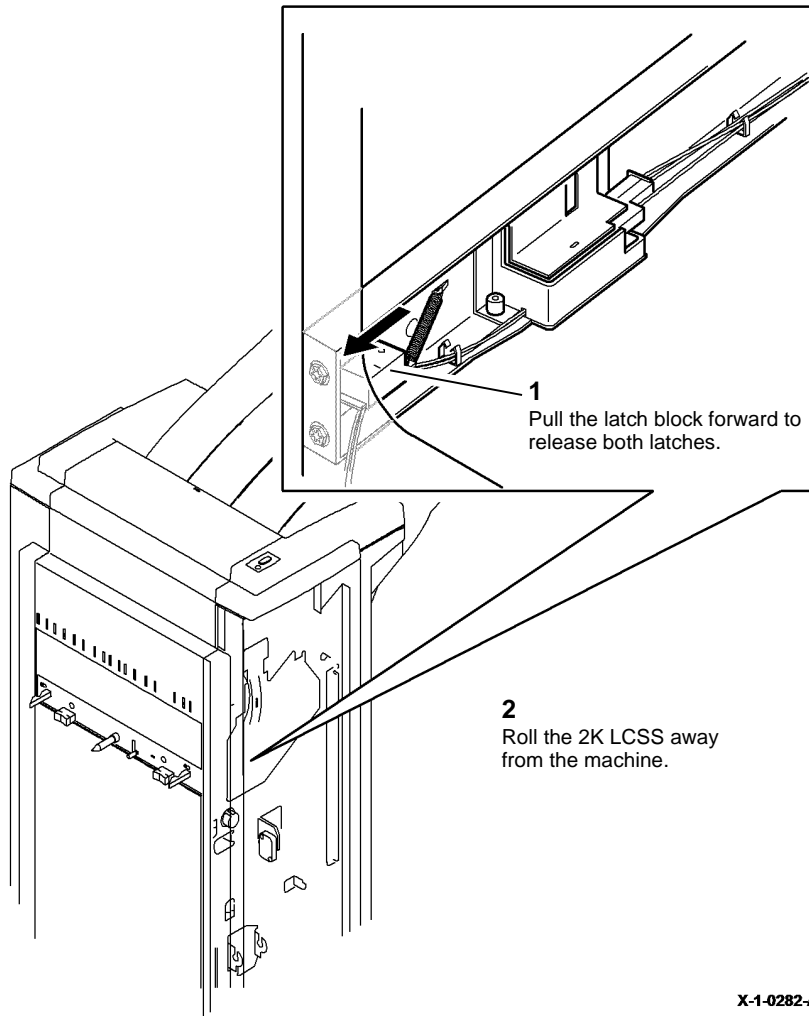
3. Release the 2K LCSS docking latch assembly, [Figure 1](#).

Figure 1 Docking latch assembly

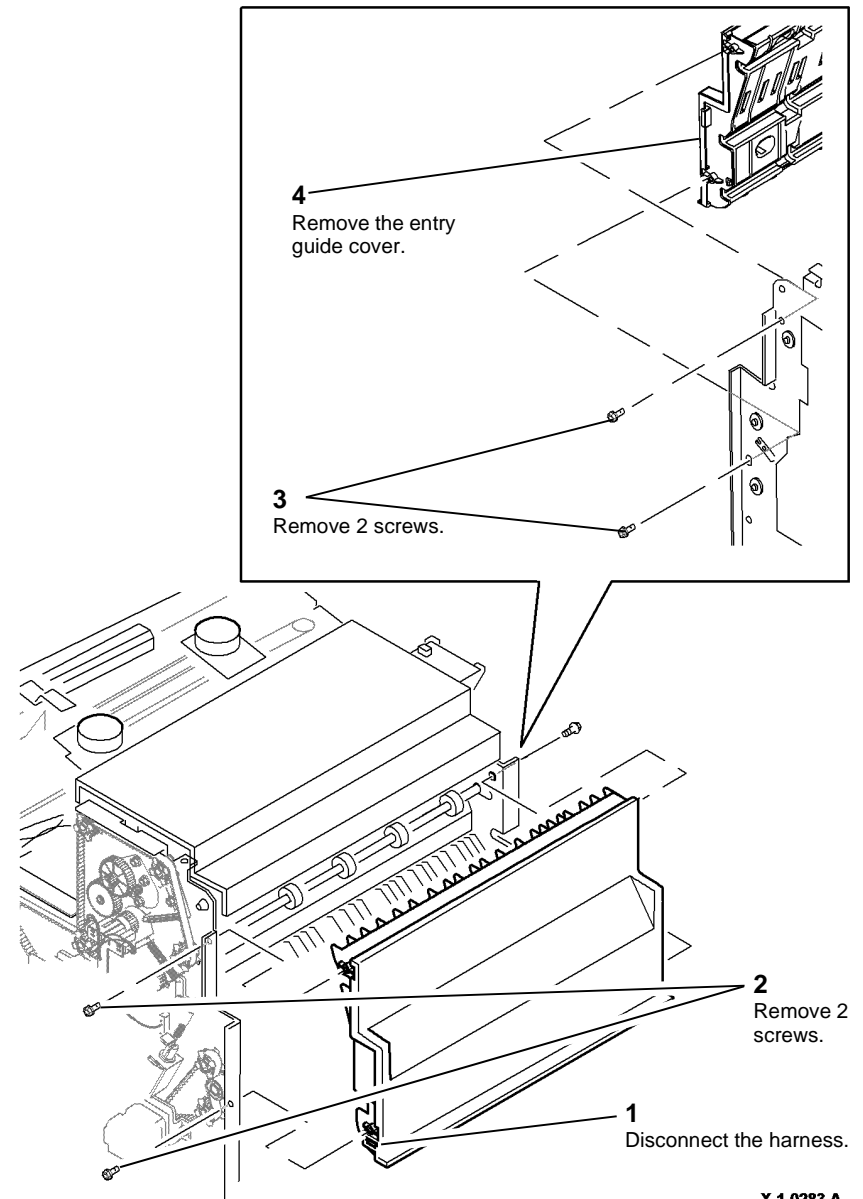
1. Un-dock the 2K LCSS, [REP 12.13-110](#) and move it away from the machine.
2. Remove the 2K LCSS covers, [REP 12.1-110](#).
3. Remove the entry guide cover, [Figure 1](#).

Figure 1 Entry guide cover removal

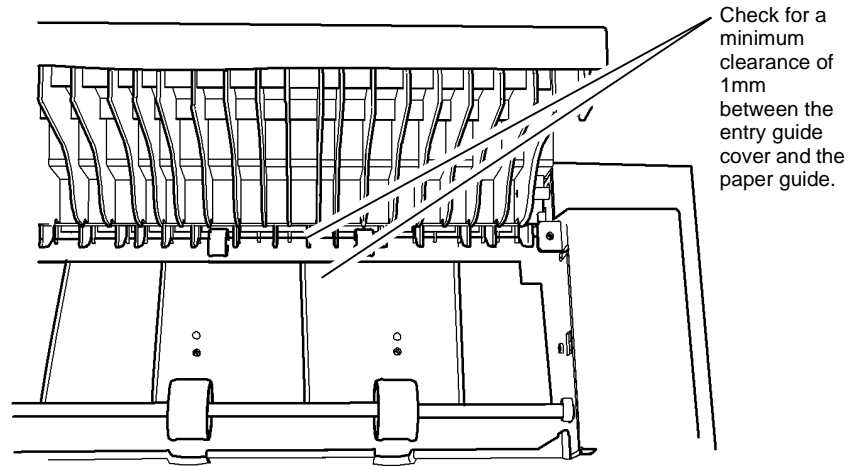
X-1-0284-A

1. Bias the entry guide cover away from the paper guide when you tighten the screws.
2. The clearance between the entry guide cover and the paper guide must be a minimum of 1 mm. Refer to [Figure 2](#).

NOTE: If the clearance is less than 1 mm, then install a new entry guide cover.

Figure 2 Entry guide cover clearance

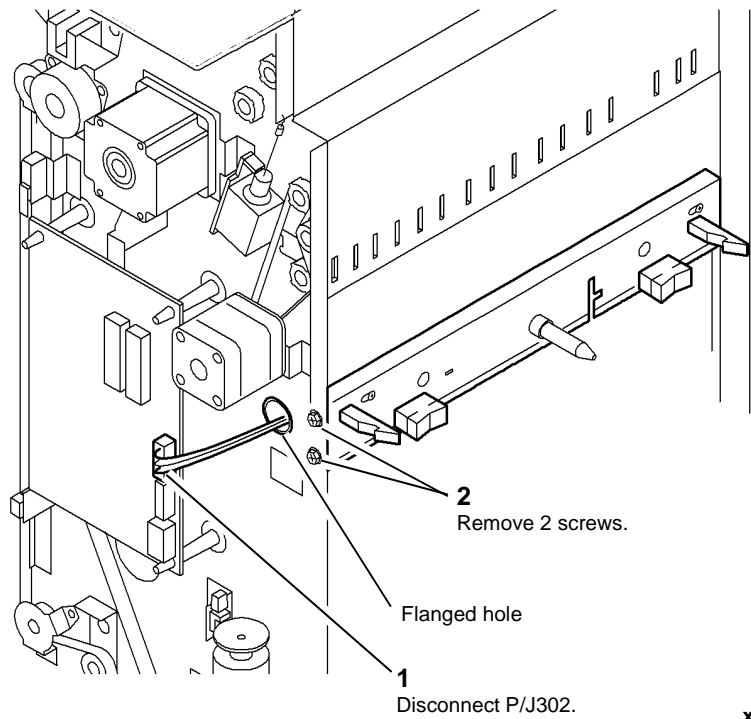
3. Prepare to remove the docking latch assembly, [Figure 1](#).

Figure 1 Preparation

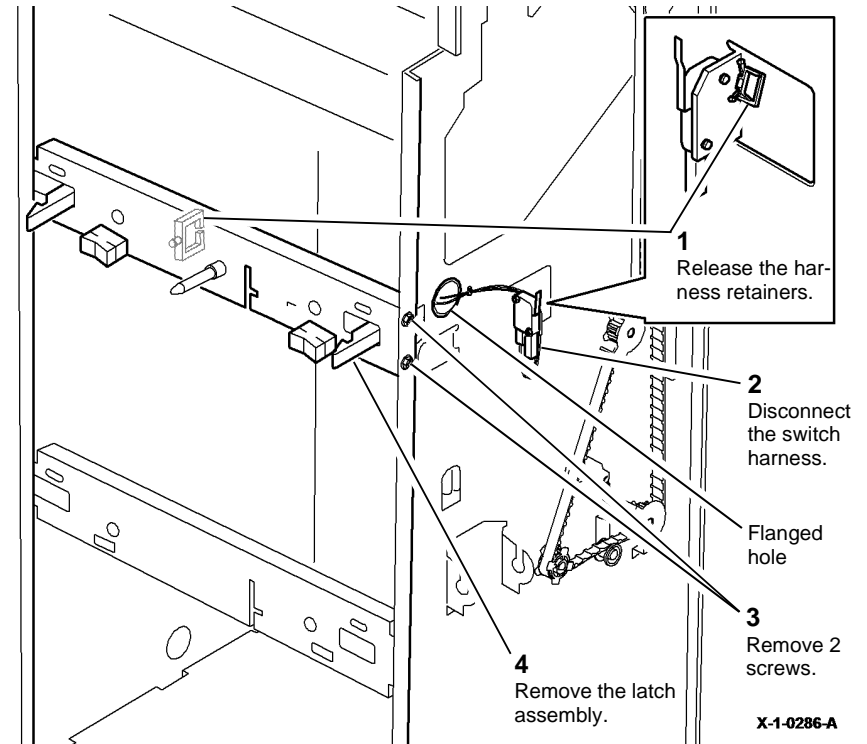
4. Remove the docking latch assembly, [Figure 2](#).

Figure 2 Latch assembly removal.

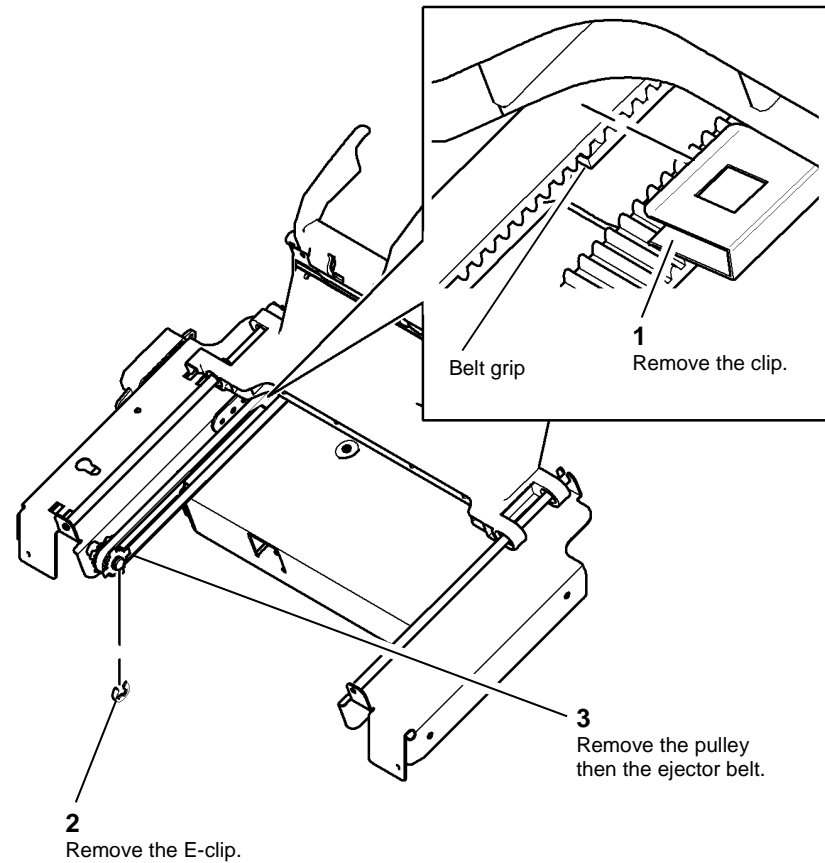
X-1-0287-A

2. Remove the ejector belt, [Figure 1](#).

Figure 1 Ejector belt removal

The replacement is the reverse of the removal procedure. Ensure that the ejector belt is correctly engaged with the belt grip on the ejector assembly before the clip is re-installed. Refer to [Figure 1](#).

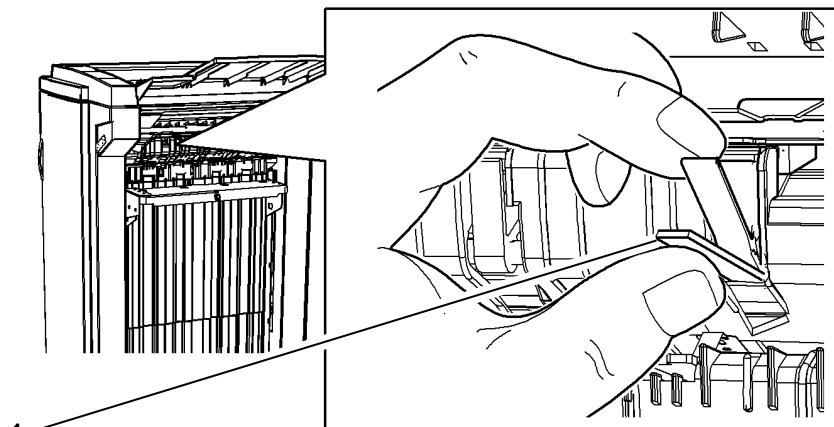
X-1-0288-A

4. Remove the paddles, [Figure 1](#).

1 Squeeze the rubber blades together and pull the paddle from the shaft

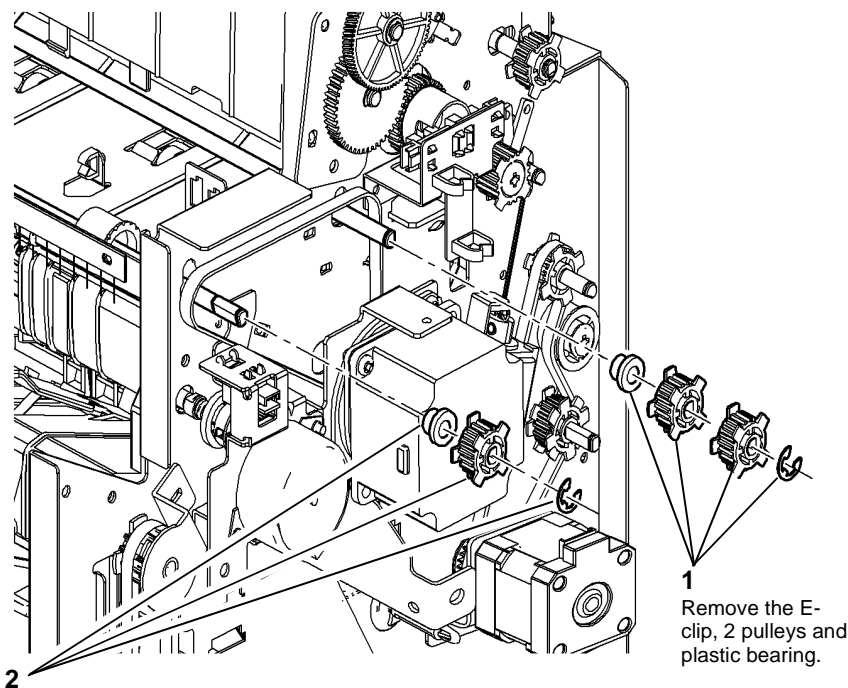
1. Remove the 2K LCSS covers, [REP 12.1-110](#).
2. Remove the tamper assembly, [REP 12.6-110](#).
3. Remove the paper output drive belt, [REP 12.4-110](#).
4. Loosen the fixing screws on transport motor 2, [PL 12.60 Item 5](#).
5. Prepare to remove the drive shafts [Figure 1](#).

2 Remove the E-clip, pulley and plastic bearing.

1 Remove the E-clip, 2 pulleys and plastic bearing.

Figure 1 Preparation

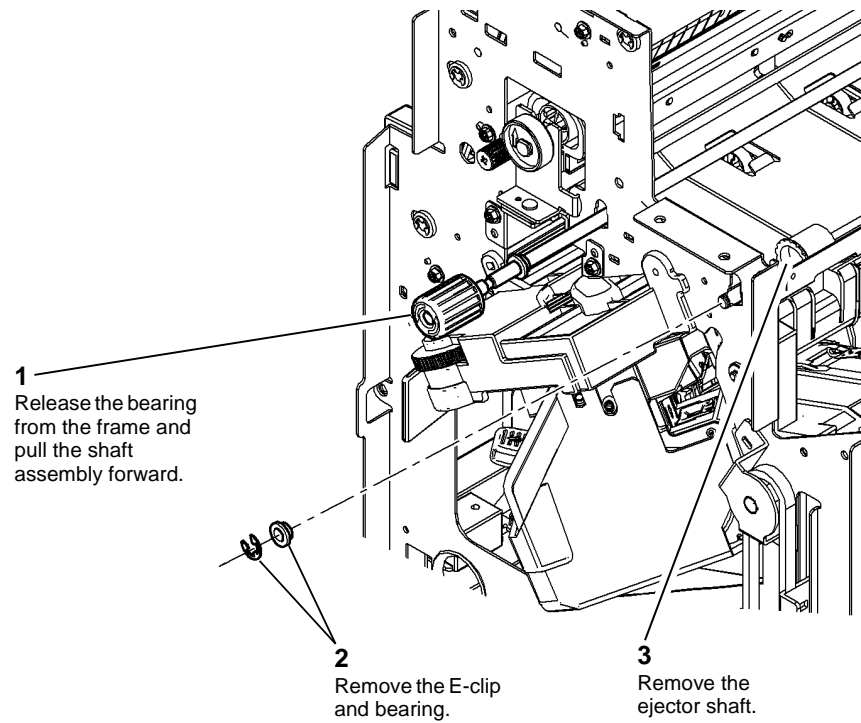
X-1-0886-A

6. Remove the ejector drive shaft, [Figure 2](#).

Figure 2 Ejector shaft removal

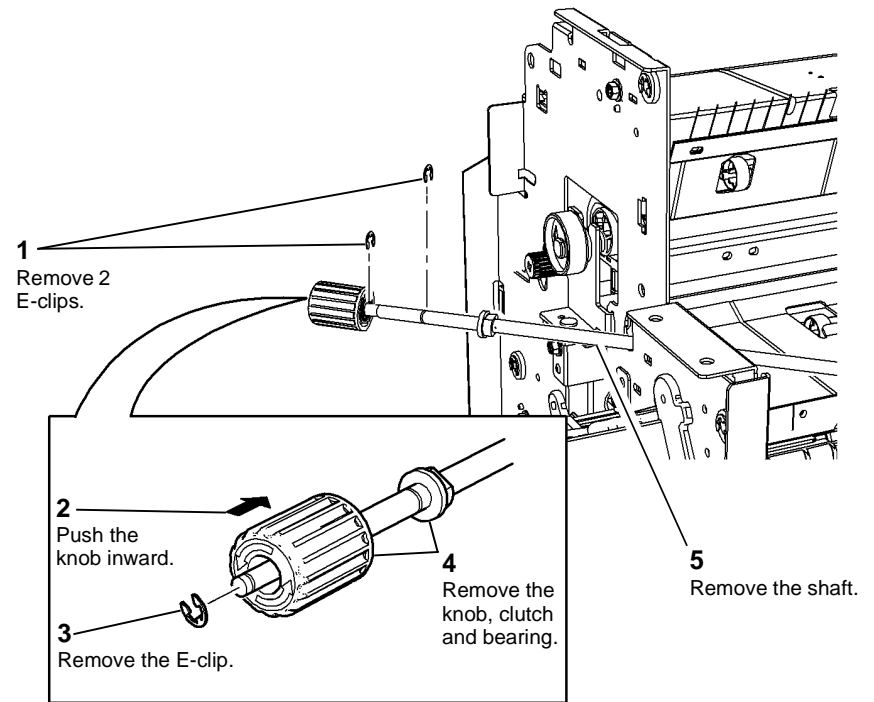
X-1-1288-A

7. Remove the drive shaft, [Figure 3](#).

Figure 3 Drive shaft removal

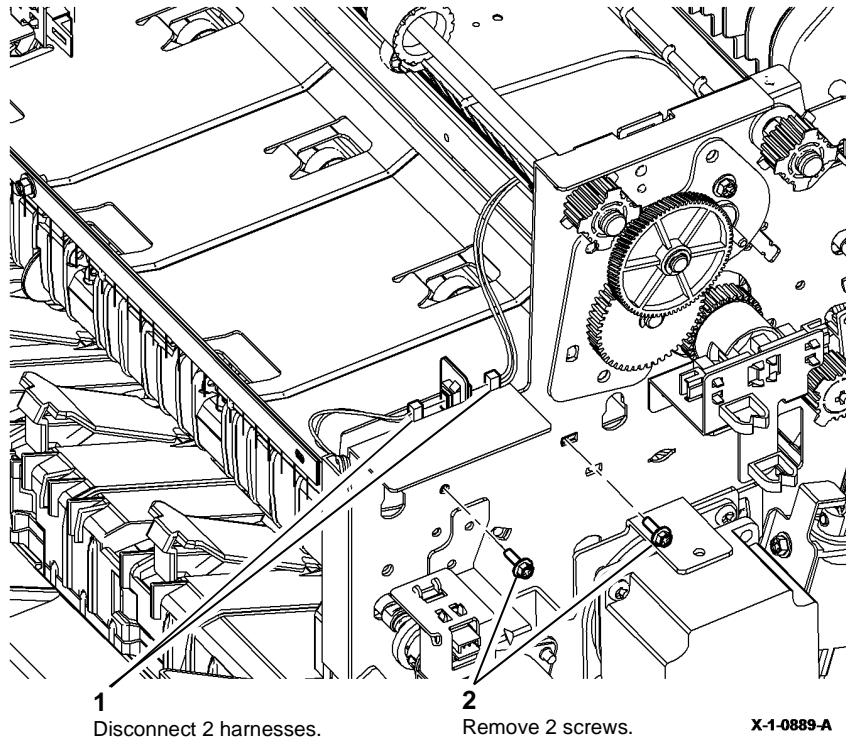
8. Prepare to remove the upper right paper guide, [Figure 4](#).

Figure 4 Preparation

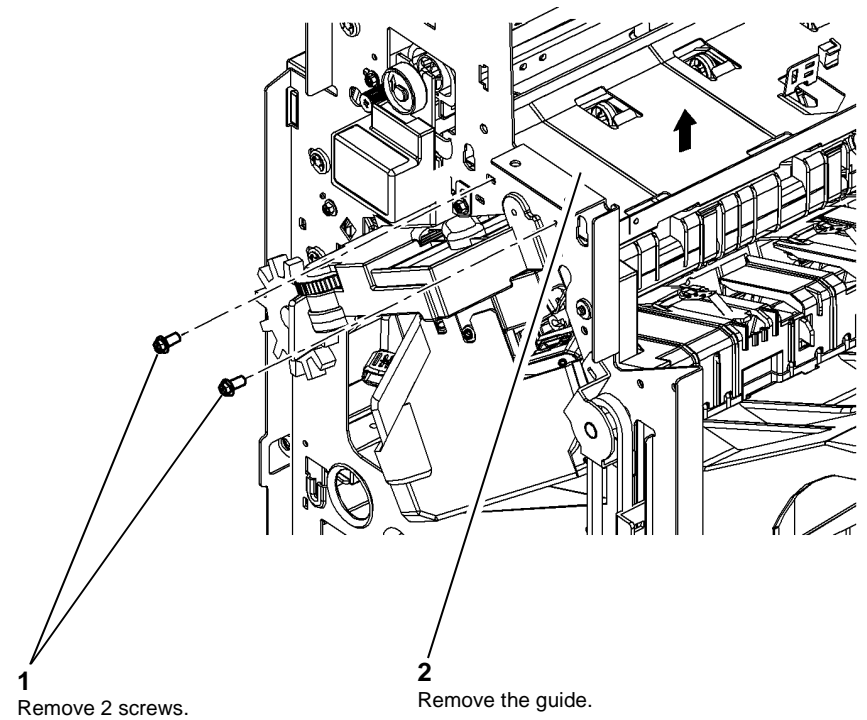
9. Remove the upper right paper guide, [Figure 5](#).

Figure 5 Upper right guide removal

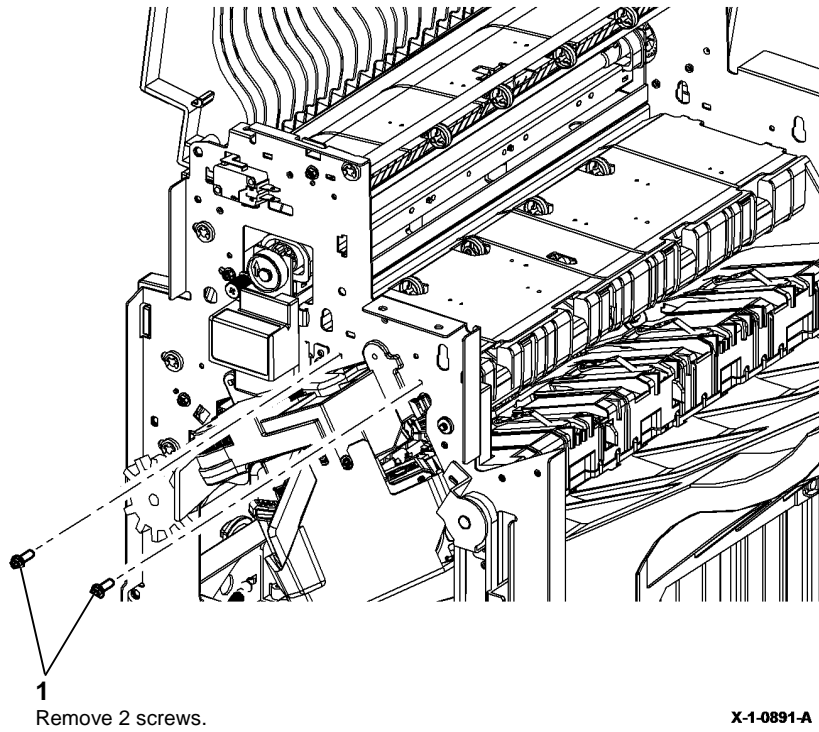
10. Prepare to remove the lower right paper guide, [Figure 6](#).

Figure 6 Preparation

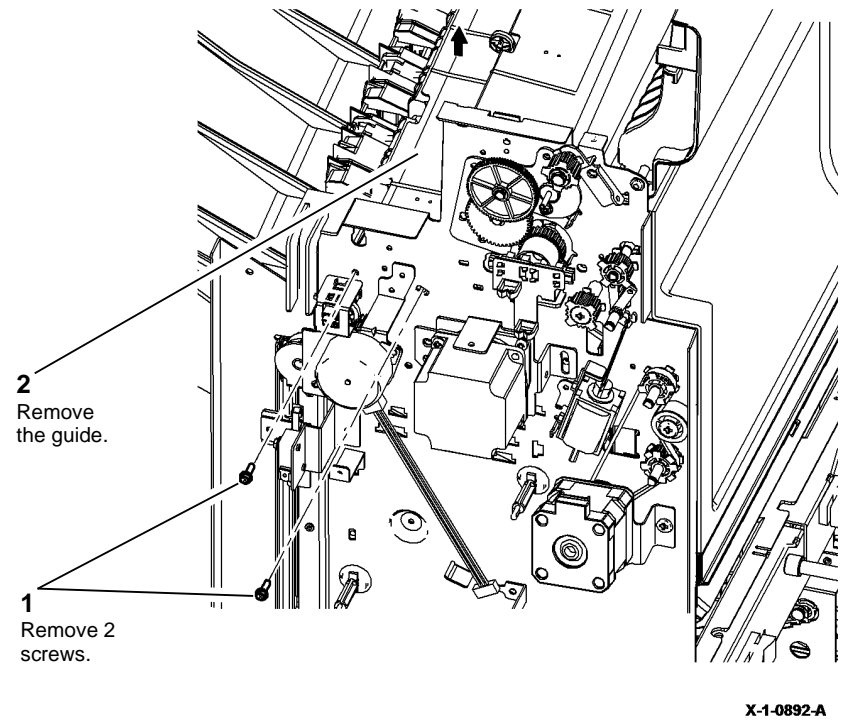
11. Remove the lower right paper guide, [Figure 7](#).

Figure 7 Lower right guide removal

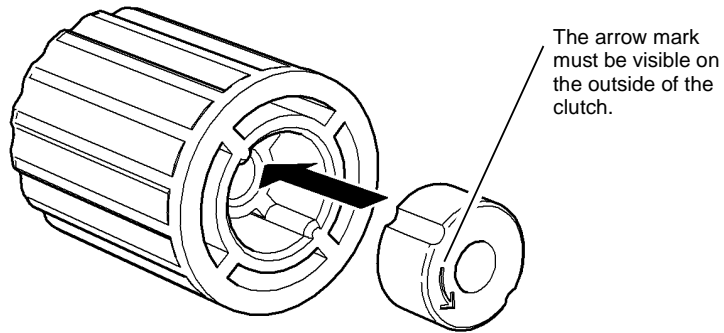
-1-1289-A

1. The replacement is the reverse of the removal procedure.
2. Ensure that the one-way-clutch inside the knob is installed correctly, [Figure 8](#).

Figure 8 Clutch orientation

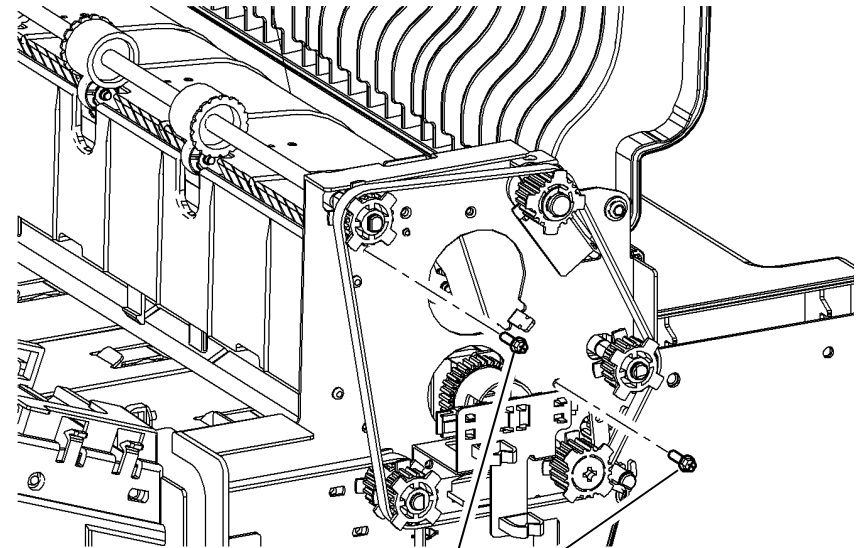
X-1-0887-A

1. Remove the 2K LCSS covers, [REP 12.1-110](#).
2. Remove the hole punch motor assembly, [REP 12.7-110](#).
3. Prepare to remove the paper guide, [Figure 1](#).

1
Remove 2 screws.

Figure 1 Preparation

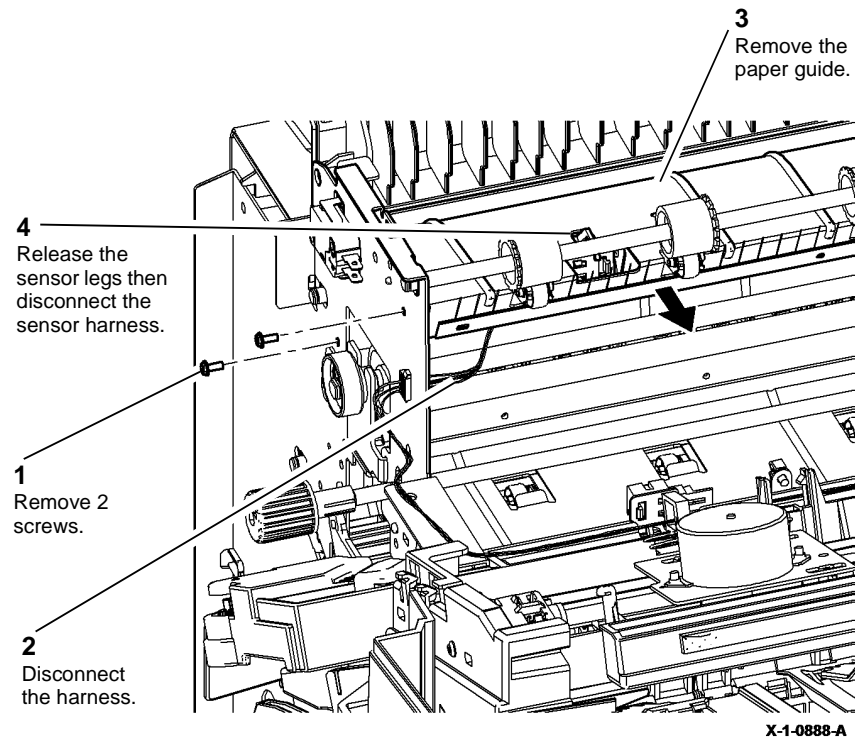
4. Remove the paper guide and top tray exit sensor, Q12-107, [Figure 2](#).

Figure 2 Guide and sensor removal

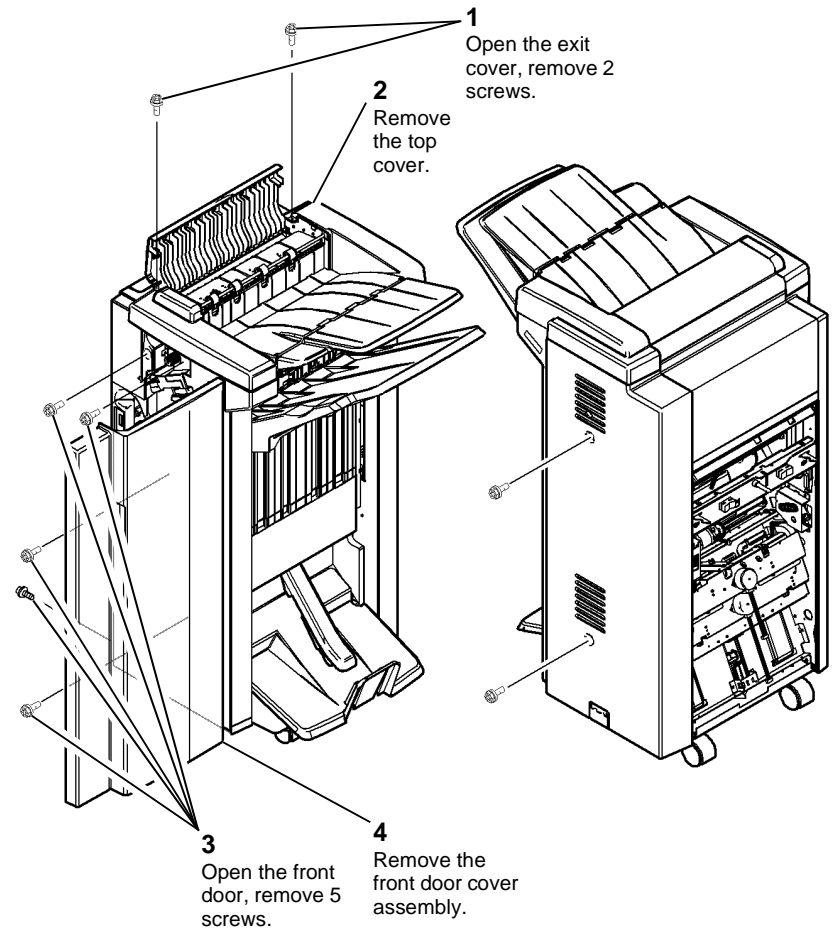
X-1-0289-A

NOTE: The front and rear covers are additionally retained by protrusions that locate in holes in the frame edges. These protrusions are best released by pulling on the bottom section of the covers.

1. Un-dock the LVF BM, [REP 12.13-150](#).
2. Remove the covers, [Figure 1](#) and [Figure 2](#).

Figure 1 Covers removal 1 of 2

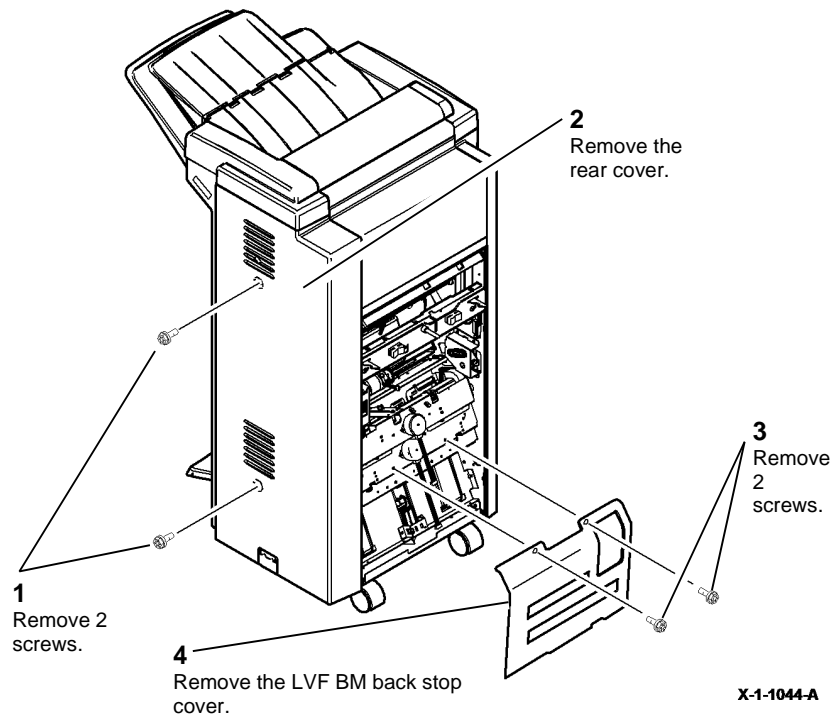
Figure 2 Covers removal 2 of 2

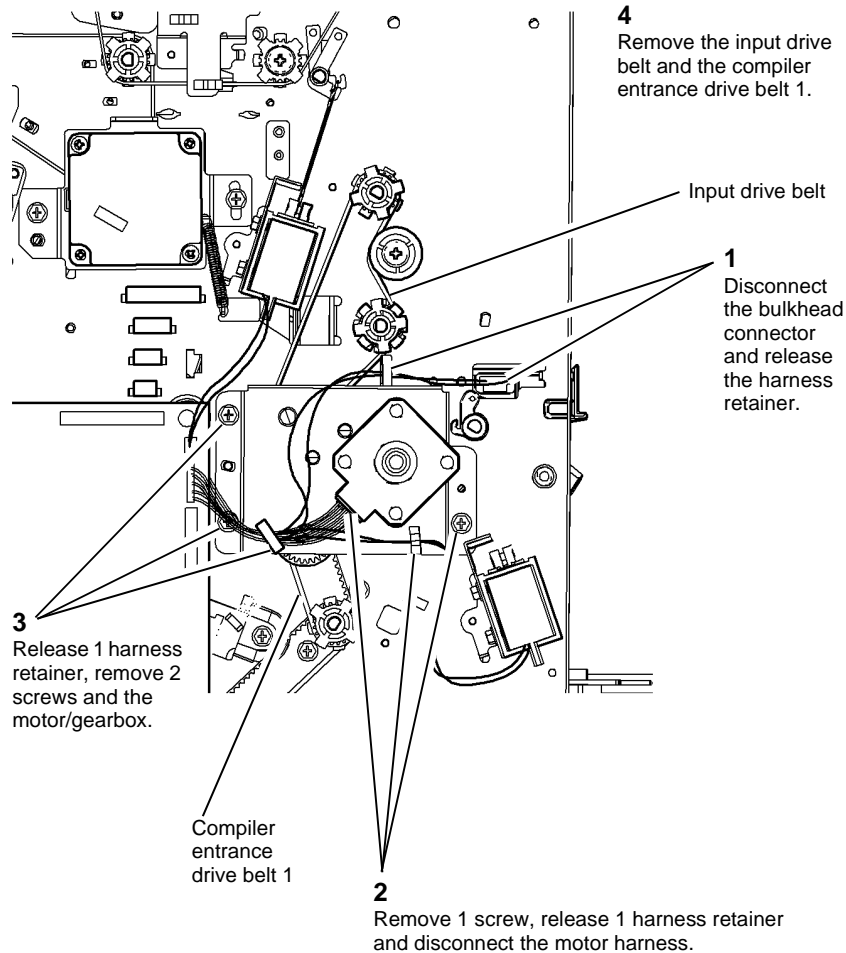
X-1-0290-A

2. Remove the motor and drive belt, [Figure 1](#).

Figure 1 Motor and drive belt removal

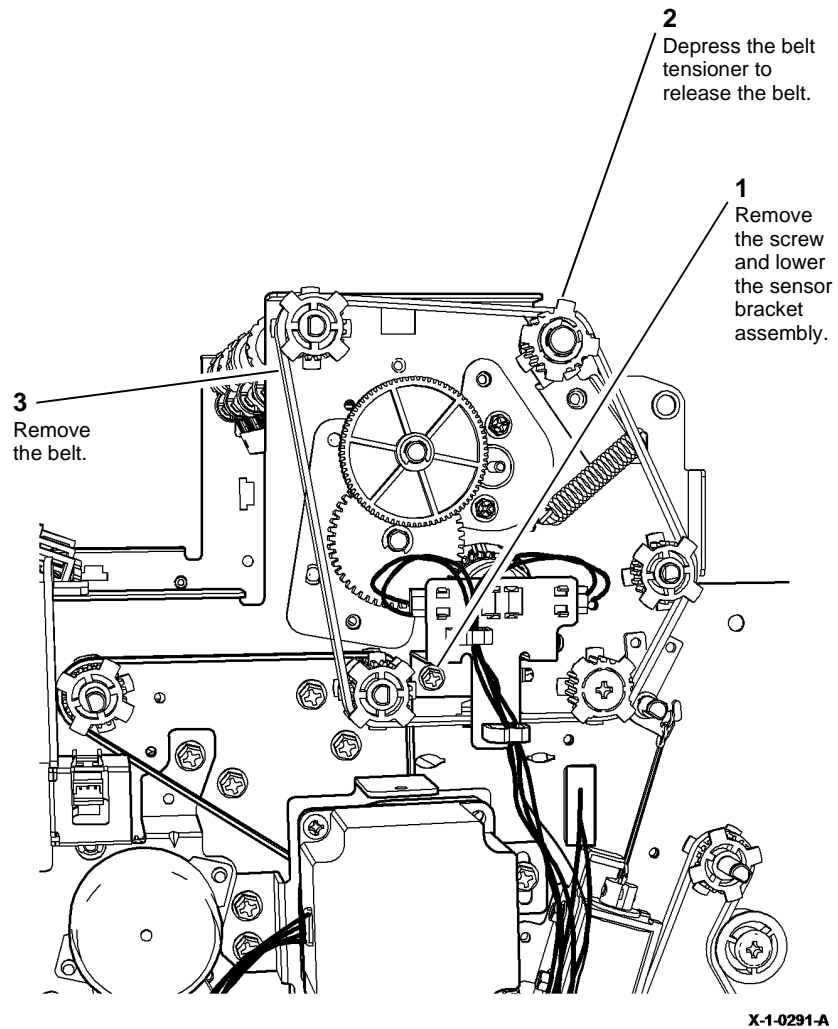
2. Remove the intermediate paper drive belt, [Figure 1](#).

Figure 1 Belt removal

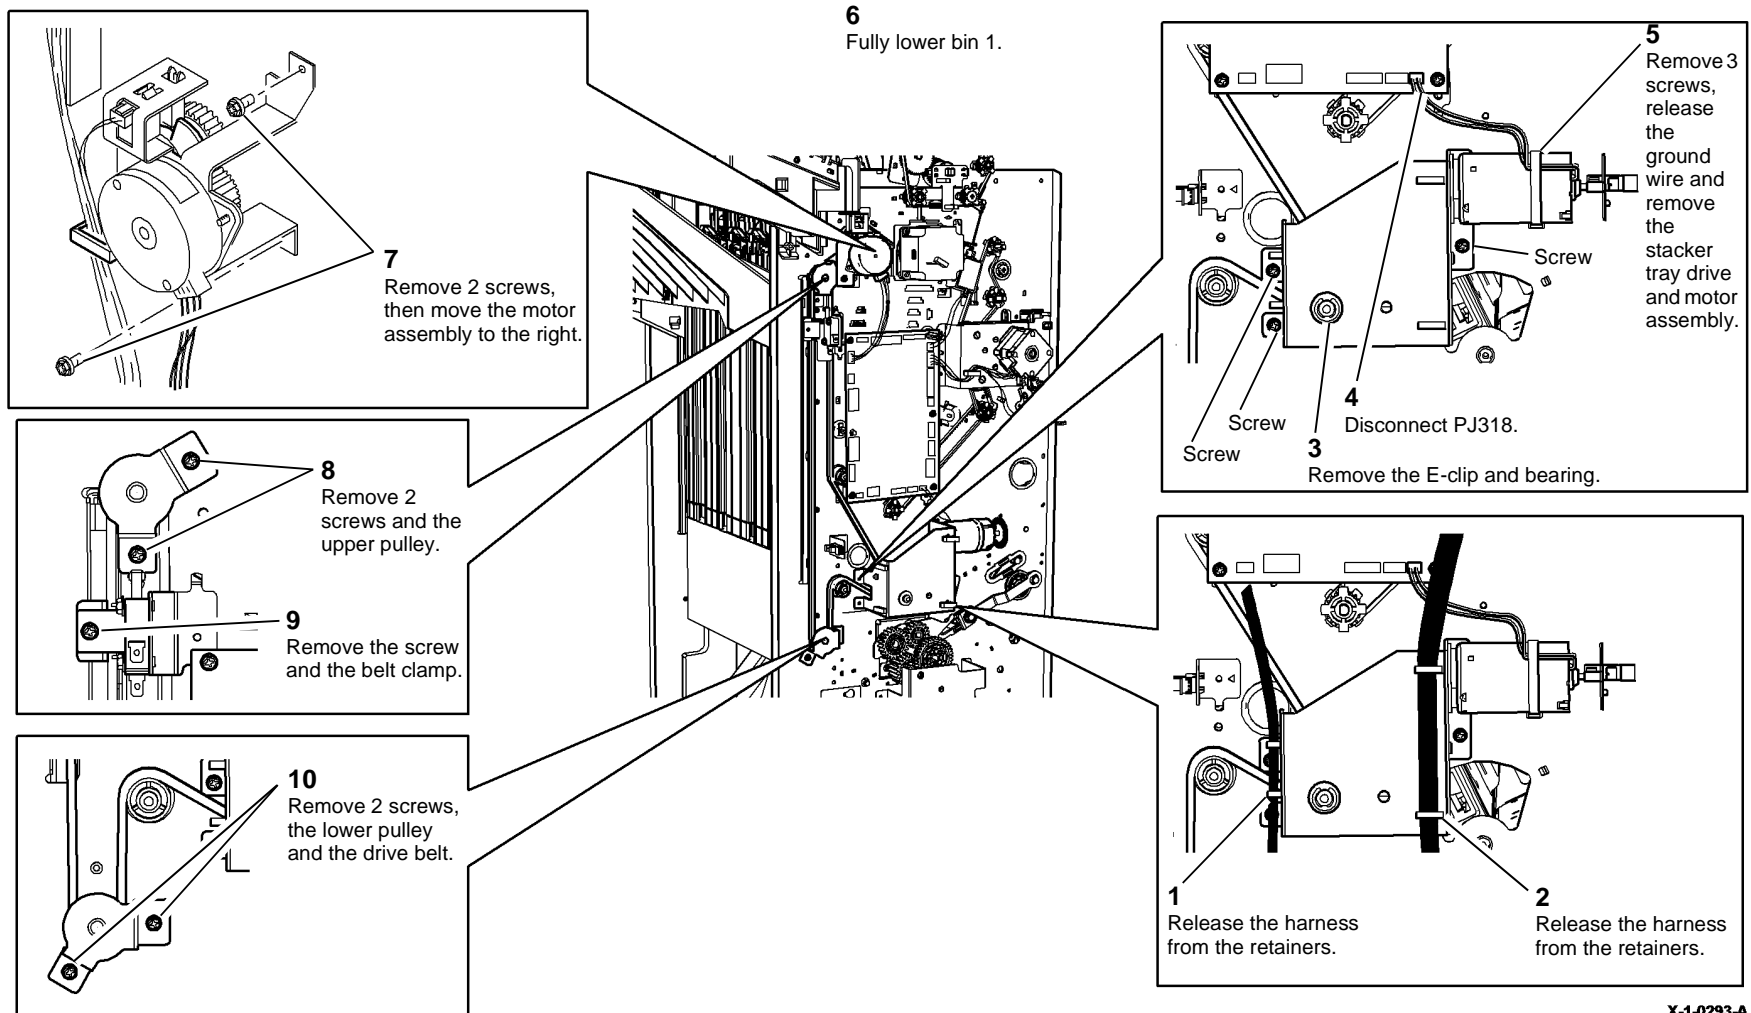
X-1-0293-A

2. Remove the bin 1 drive belt (rear), **Figure 1**.

NOTE: Keep all of the components removed as a set. The set of rear frame components are different from the front frame set.

Figure 1 Bin 1 drive belt (rear)

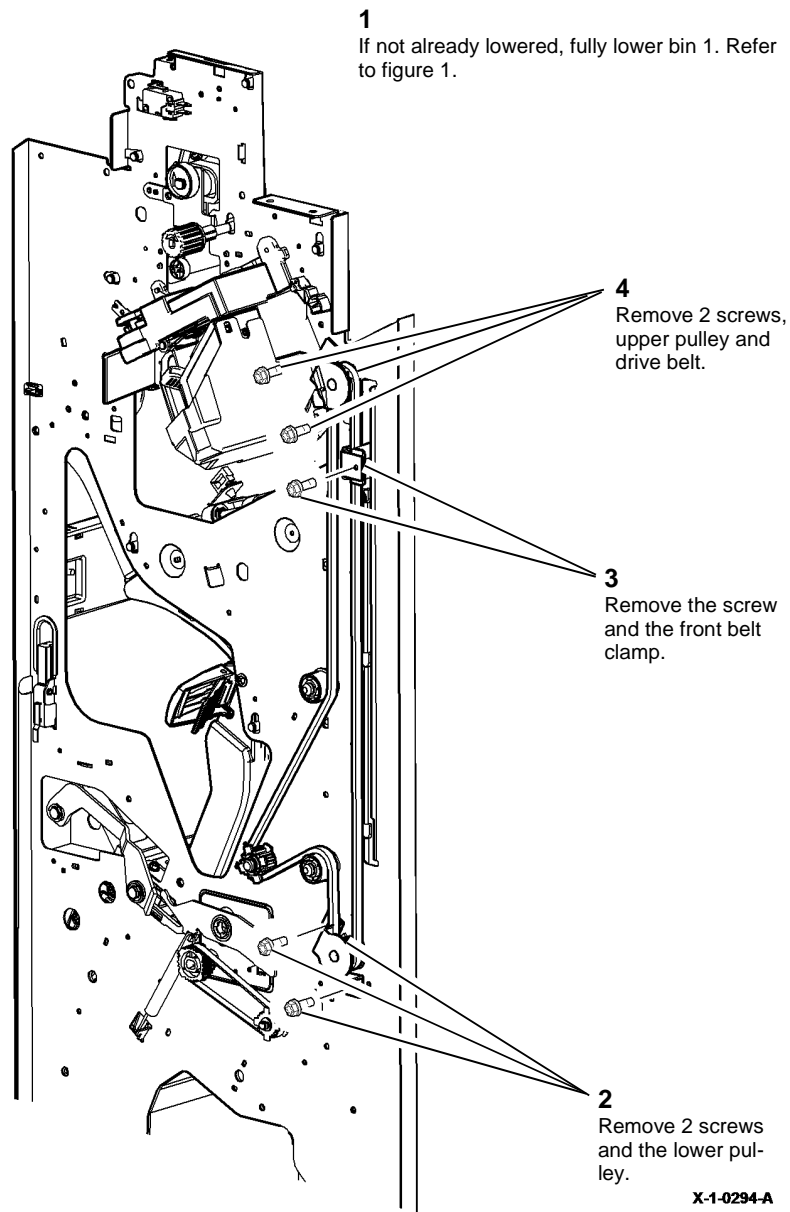
3. Remove the bin 1 drive belt (front) [Figure 2](#).

Figure 2 Bin 1 drive belt (front)

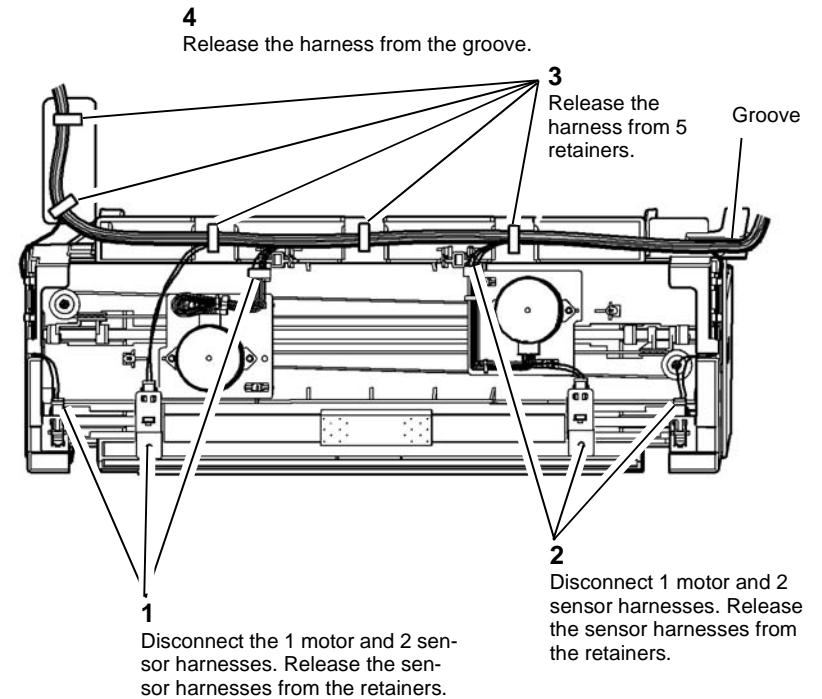
X-1-0295-A

1. Remove the LVF BM covers [REP 12.1-150](#).
2. Remove bin 1 (1 K-L clip).
3. Prepare to remove the tamper assembly [Figure 1](#).

Figure 1 Preparation

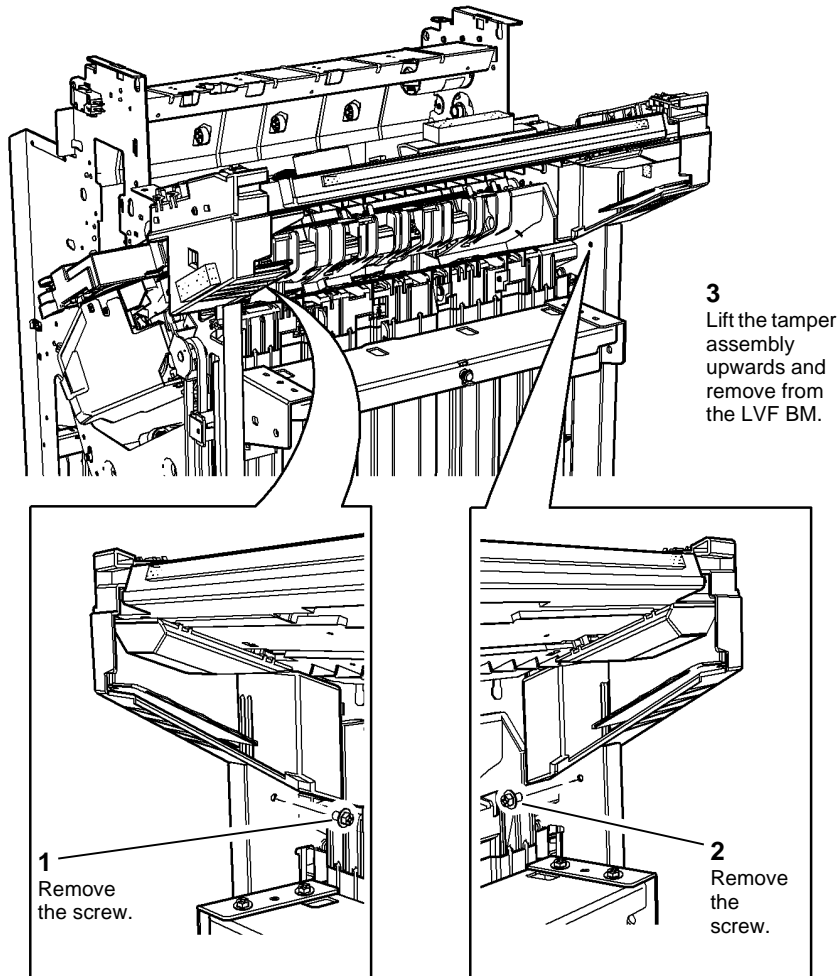
X-1-0296-A

4. Remove the tamper assembly, [Figure 2](#).

Figure 2 Removing the tamper assembly

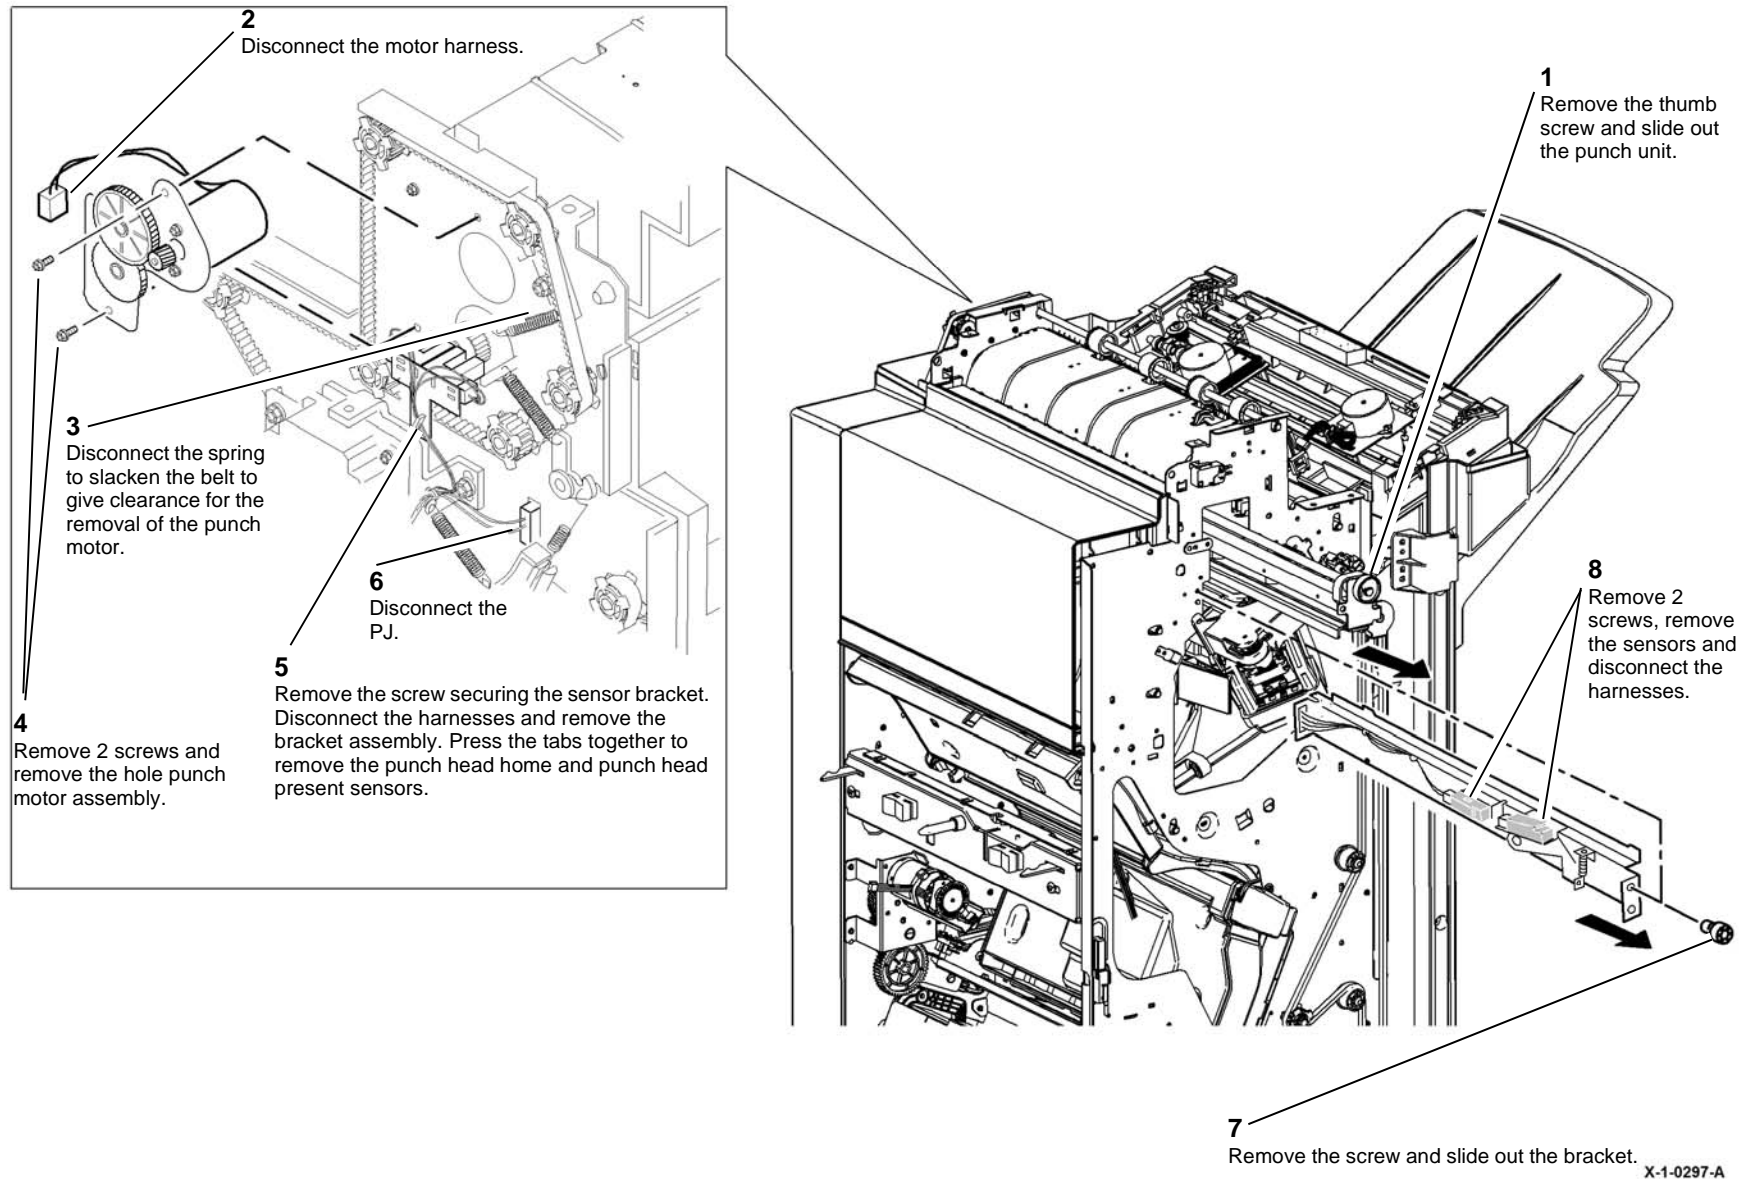
3. Remove the hole punch unit, motor assembly and sensors, [Figure 1](#).

Figure 1 Removal

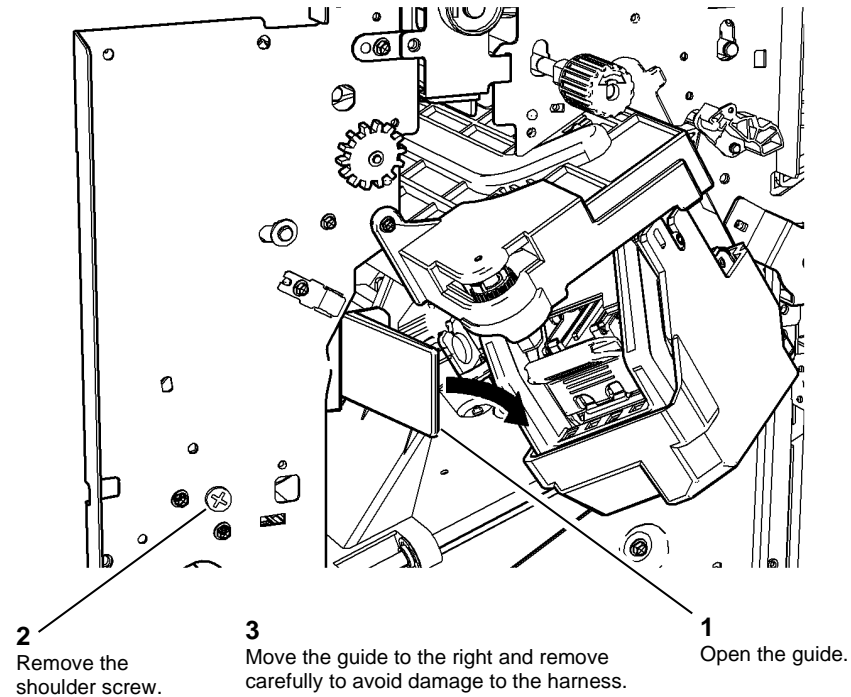
X-1-0298-A

4. Remove the paper entry guide assembly, [Figure 1](#).

Figure 1 Paper entry guide removal

1. Refer to [GP 6](#) before re-fitting screws into plastic components.
2. When installing the stapler harness, ensure that the cable marking tie-wraps are positioned between the 2 harness retainers, [Figure 3](#).
3. Ensure that the stapling traverse assembly is engaged on the front and rear locating dowels.
4. Ensure that the stapler harness does not interfere with the paper entry guide assembly, [Figure 1](#).
5. Reverse the removal procedure to replace the stapling unit.
