708P91368
September 2017

Xerox® AltaLink® B8090 Family Multifunction Printer Service Manual

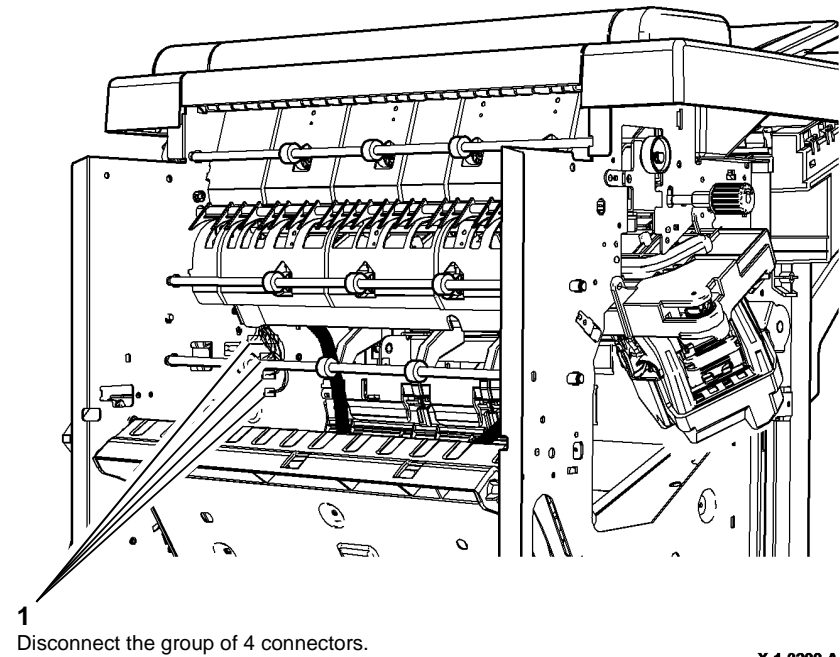
X-1-0299-A

6. Disconnect the harness, [Figure 2](#).

Figure 2 Harness disconnection

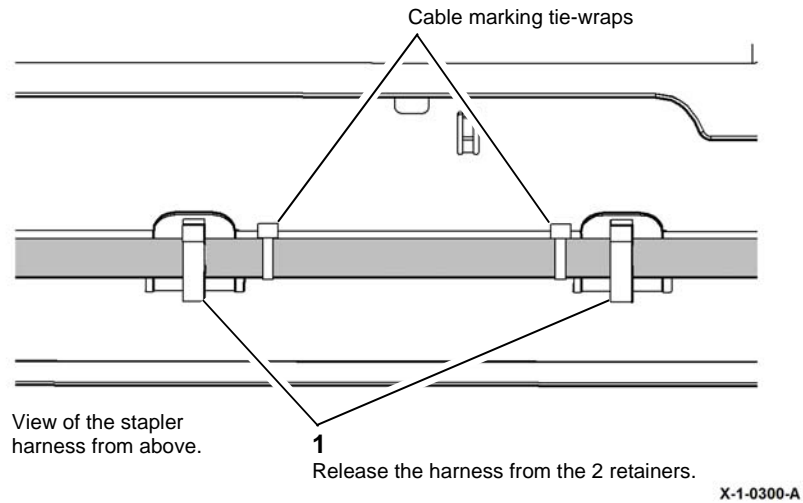
7. Release the stapler harness, [Figure 3](#).

Figure 3 Harness release

1. Refer to [GP 6](#) before re-fitting screws into plastic components.
2. When installing the stapler harness, ensure that the cable marking tie-wraps are positioned between the 2 harness retainers, [Figure 3](#).
3. Ensure that the stapling traverse assembly is engaged on the front and rear locating dowels.
4. Ensure that the stapler harness does not interfere with the paper entry guide assembly, [Figure 1](#).
5. Reverse the removal procedure to replace the stapling unit.

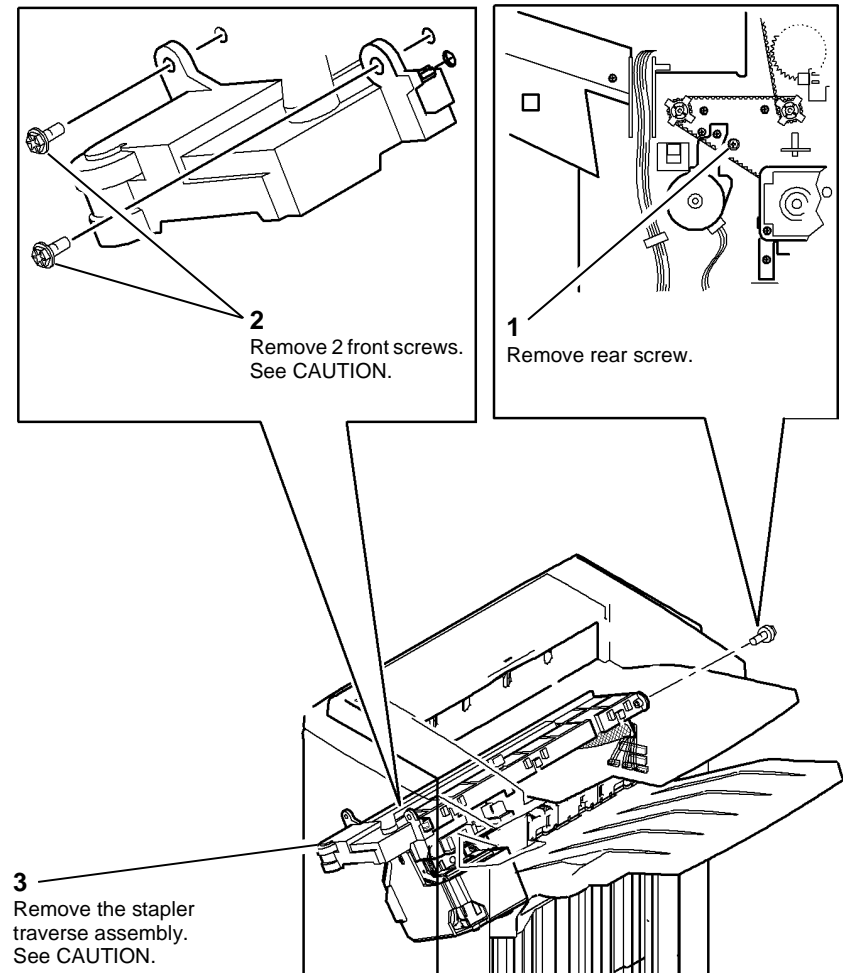
When removing and replacing the stapler traverse assembly, support the weight of the assembly underneath the stapler and take care not to damage wiring.

8. Remove the stapler traverse assembly, [Figure 4](#).

Figure 4 Traverse assembly removal

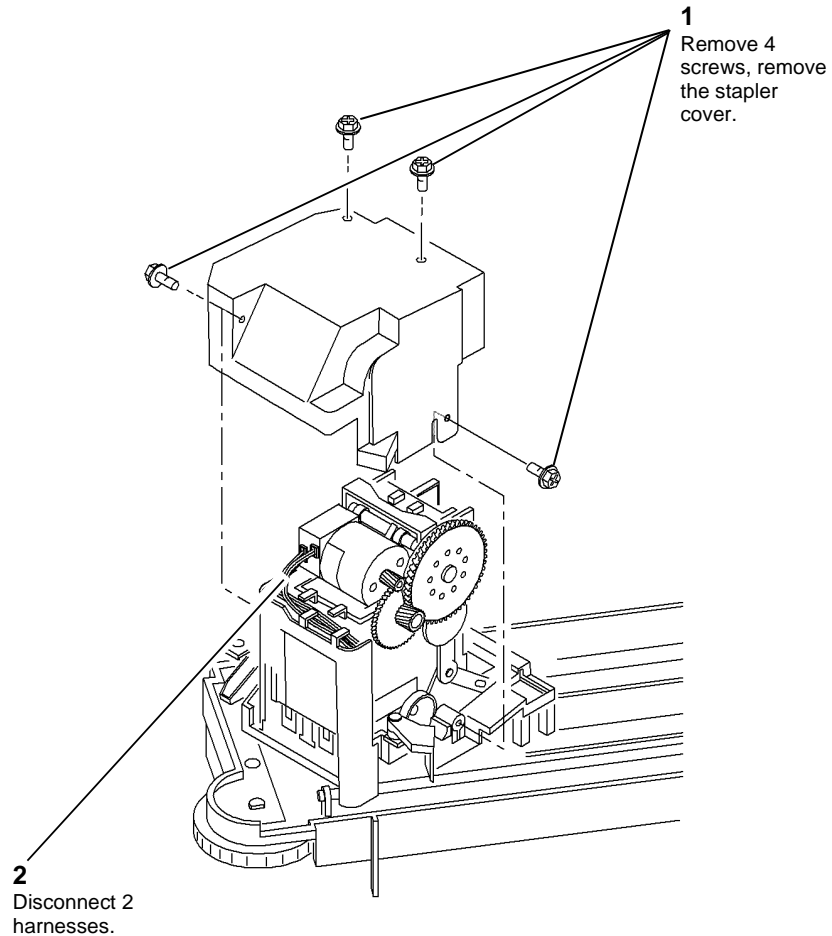
X-1-0302-A

3. Remove the staple head unit from the stapling unit, [Figure 1](#).

Figure 1 Staple head unit removal

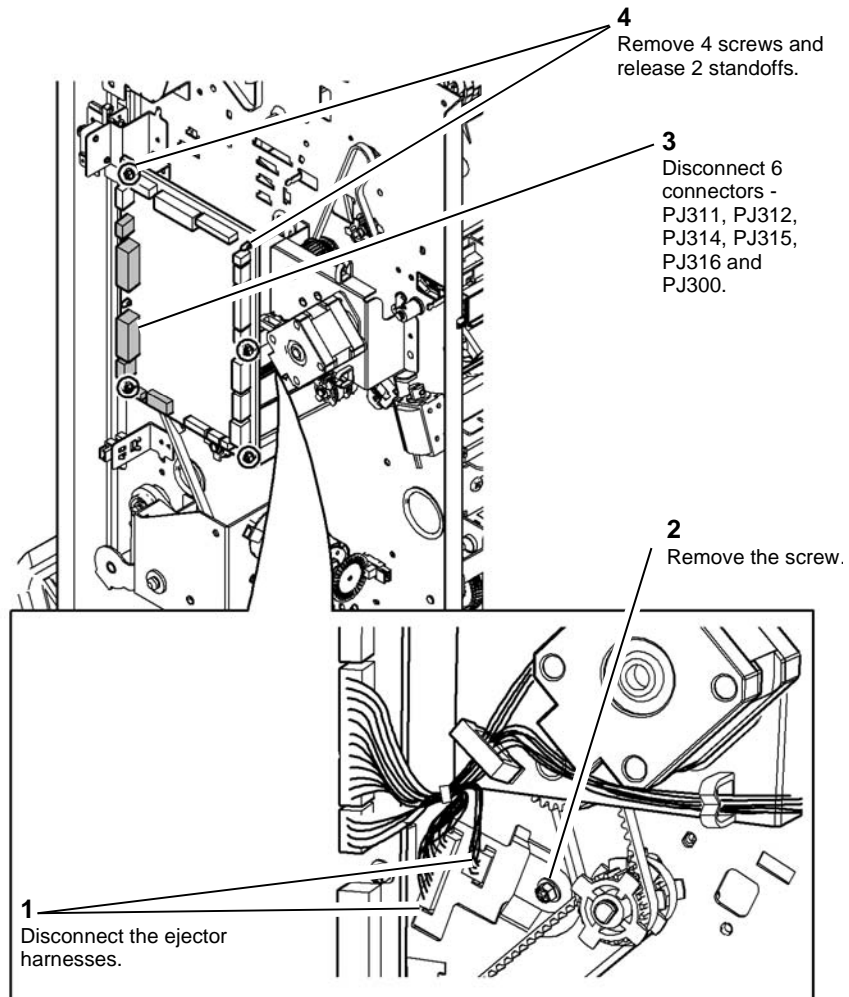
X-1-0303-A

4. Prepare to remove the ejector assembly, [Figure 2](#) and [Figure 3](#).

Figure 2 Preparation 1

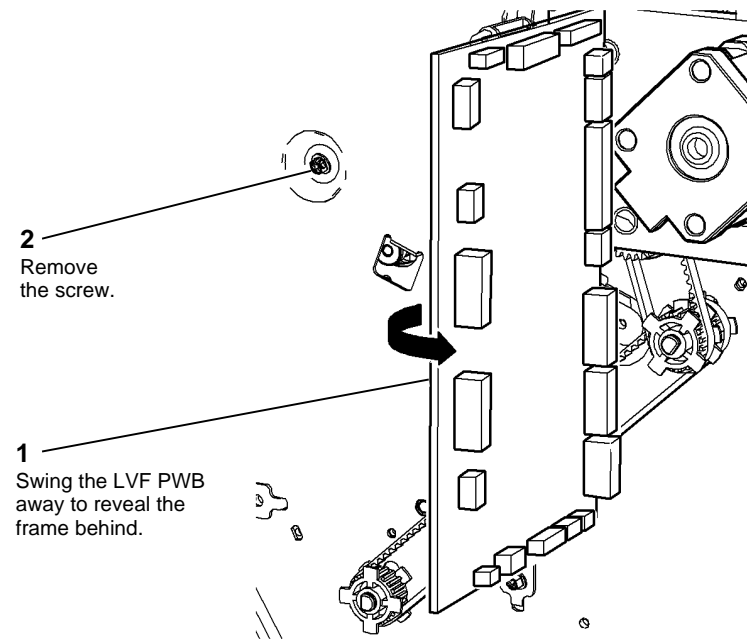
X-1-0304-A

Figure 3 Preparation 2

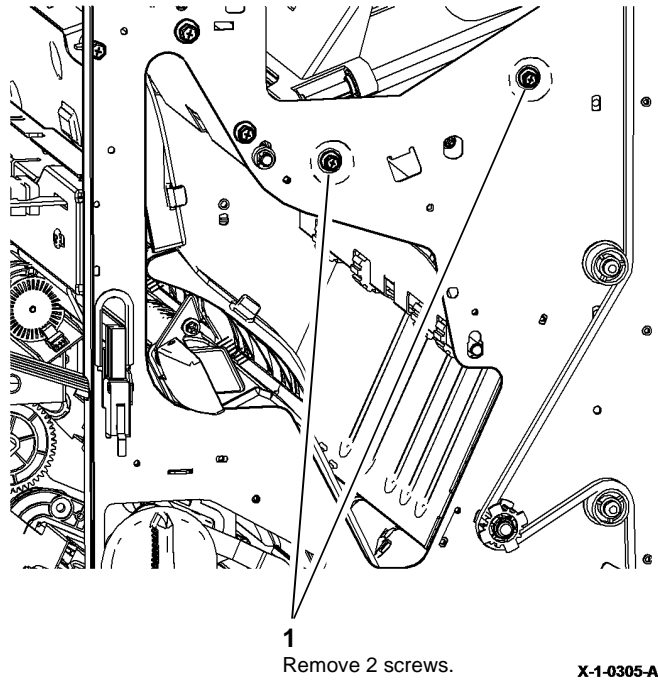
5. Remove the front fixings, [Figure 4](#).

Figure 4 Front fixings removal

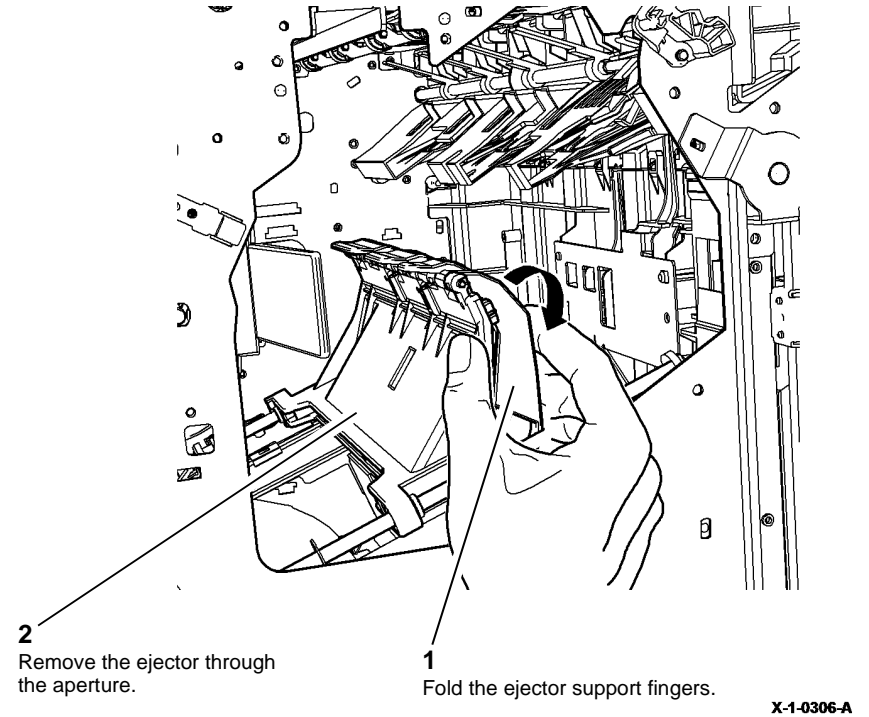
6. Remove the ejector assembly, [Figure 5](#).

Figure 5 Ejector assembly removal

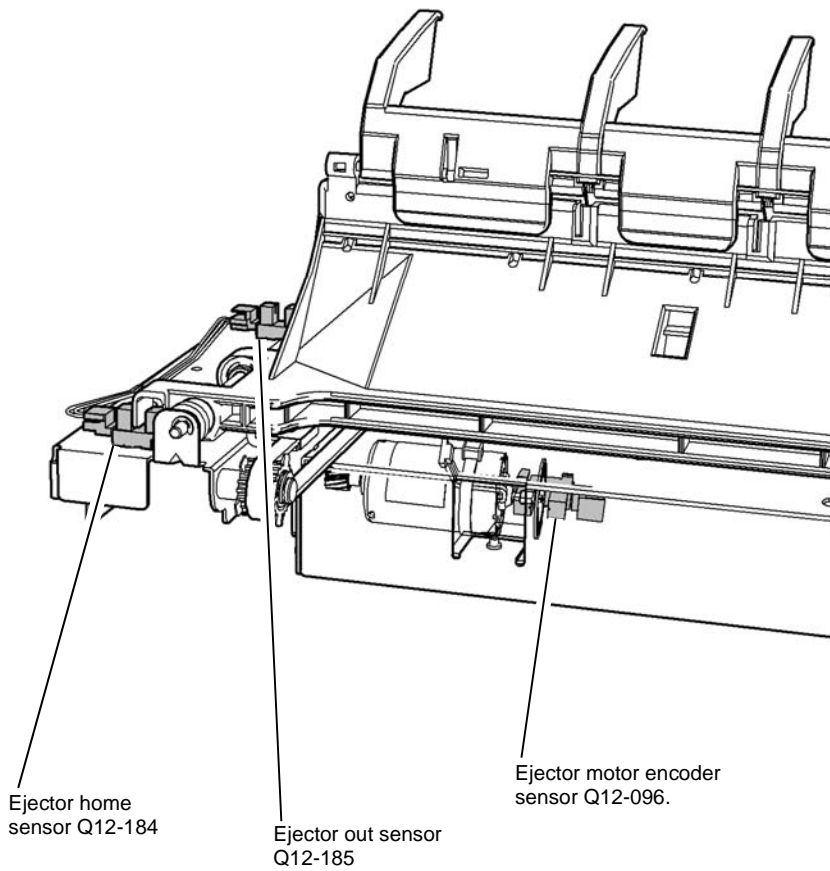
X-1-0307-A

7. If required, remove the appropriate sensor, [Figure 6](#).

Figure 6 Sensor removal

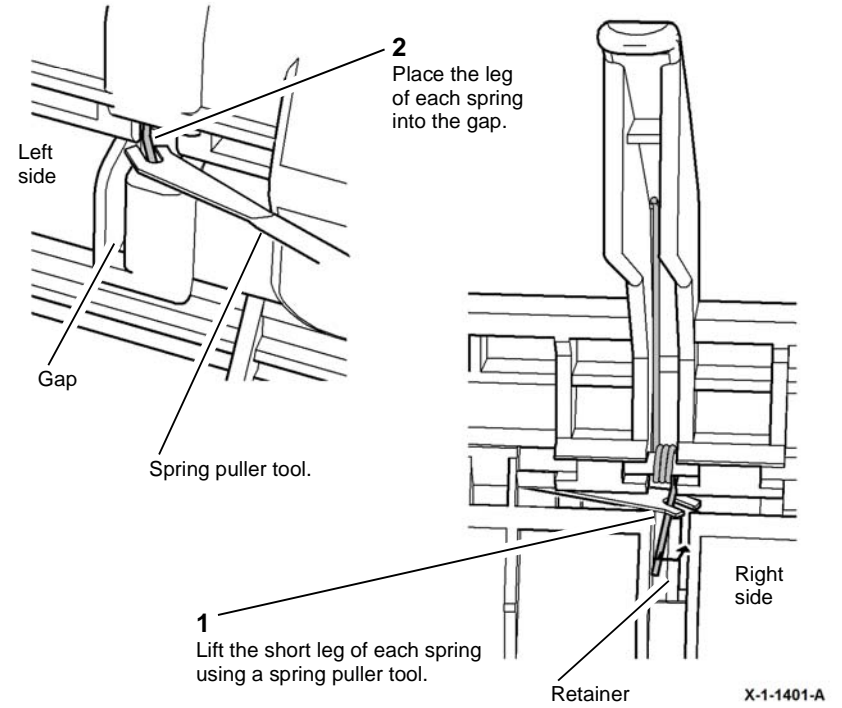
X-1-1401-A

8. If required, prepare to remove the support finger, [Figure 7](#).

Figure 7 Preparation

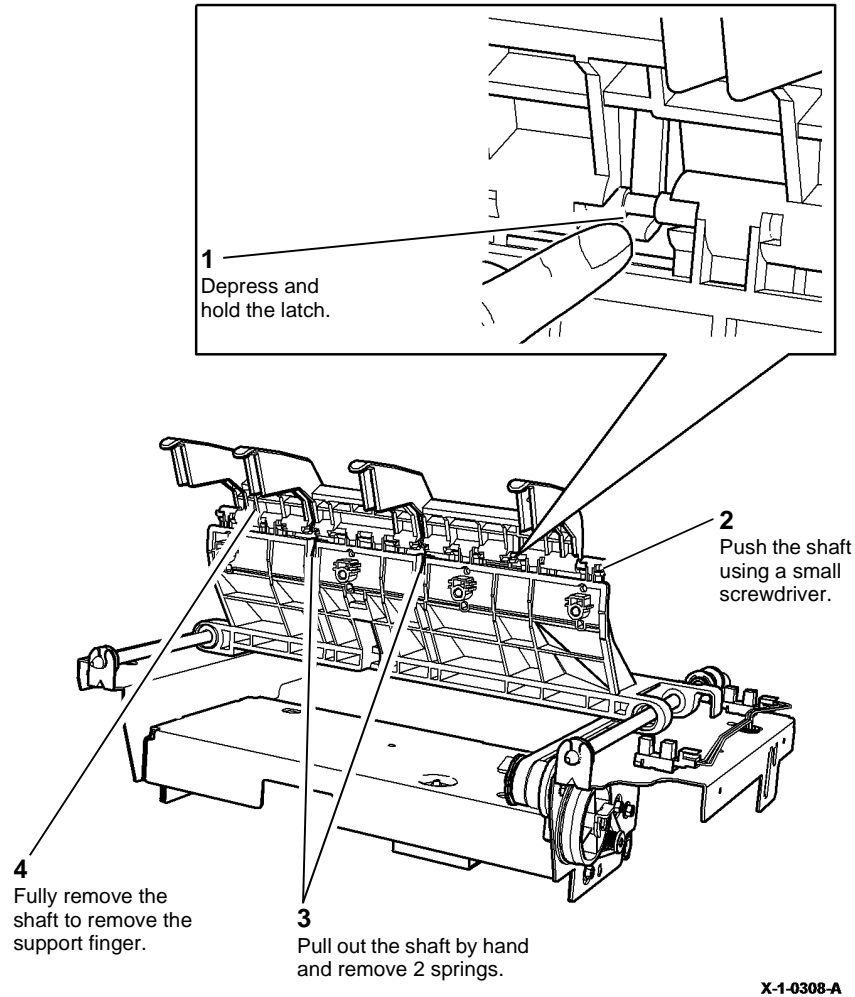
9. Remove the support finger, [Figure 8](#).

Figure 8 Support finger removal

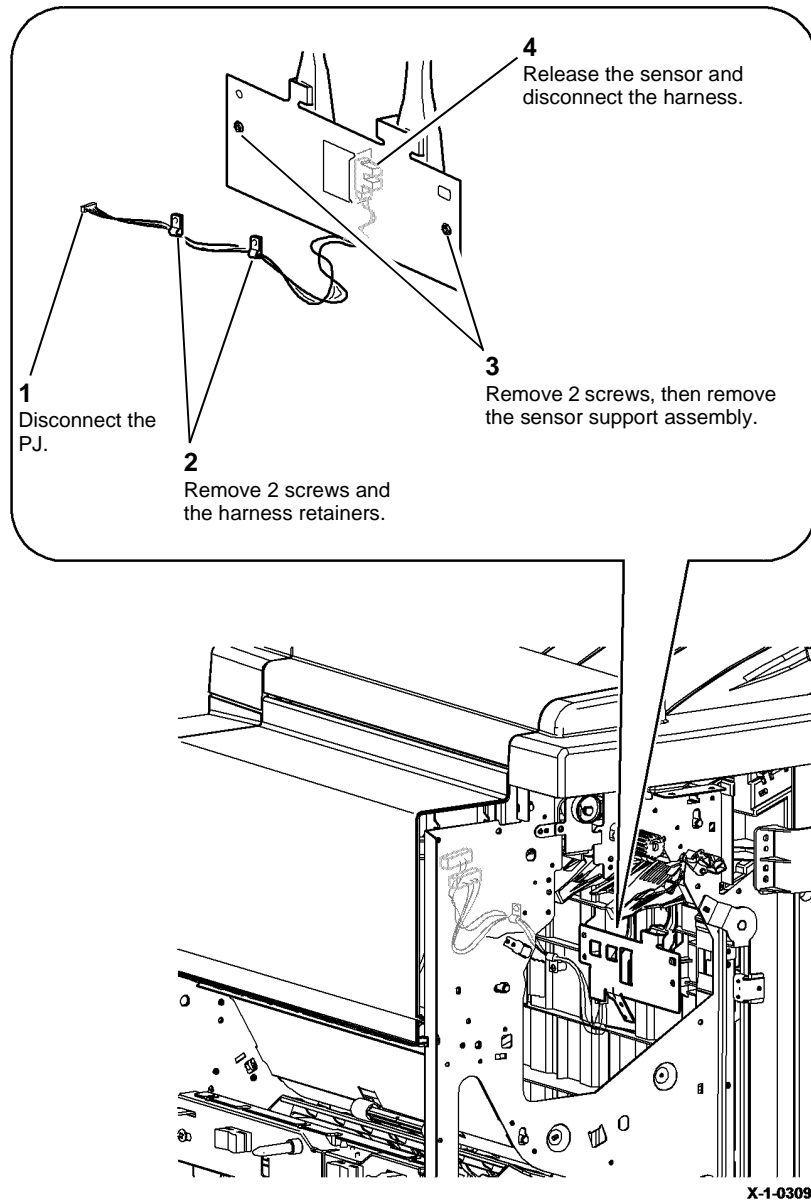
2. Remove the bin 1 upper level sensor [Figure 1](#).

Figure 1 Bin 1 level sensors removal

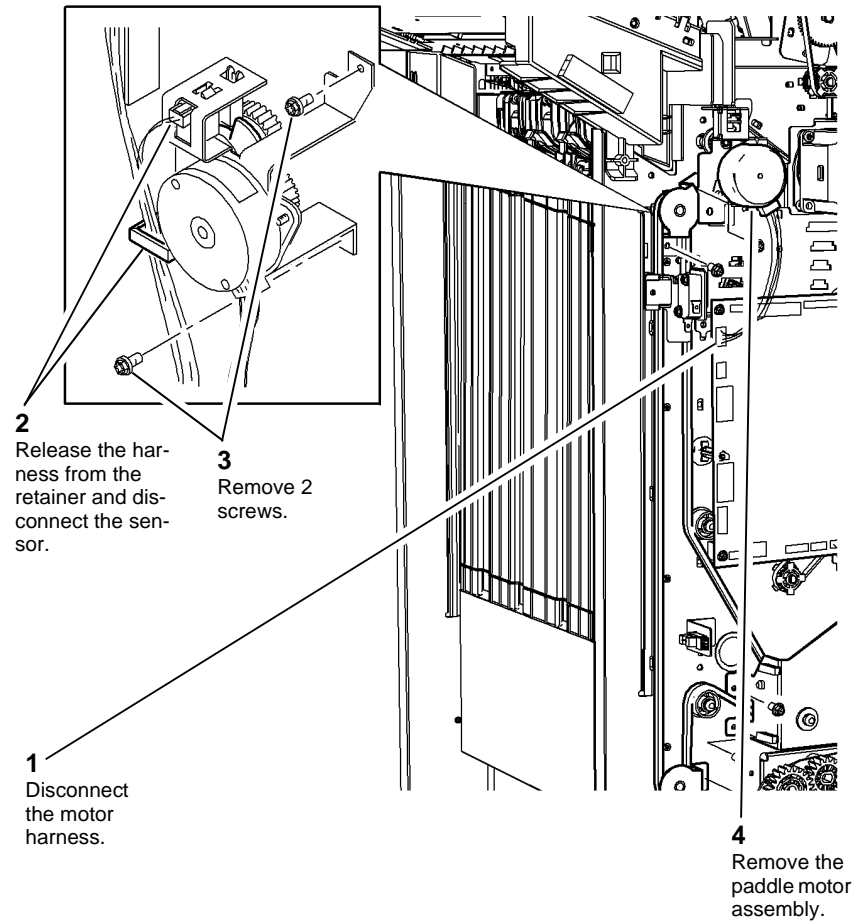
X-1-0310-A

3. Remove the paddle motor assembly, [Figure 1](#).

Figure 1 Paddle motor assembly

- Refer to [GP 6](#) before refitting the screws.
- Install the paddle shaft. Install the front E-clip.
- Install the output cover, [Figure 4](#).
- Install the rear bearing and E-clip.
- Install the gear and flag assembly with the E-clip. Ensure that it locates onto the "D" flat, [Figure 2](#).
- Install the motor assembly, [Figure 1](#).
- Install the tamper assembly and bin 1.

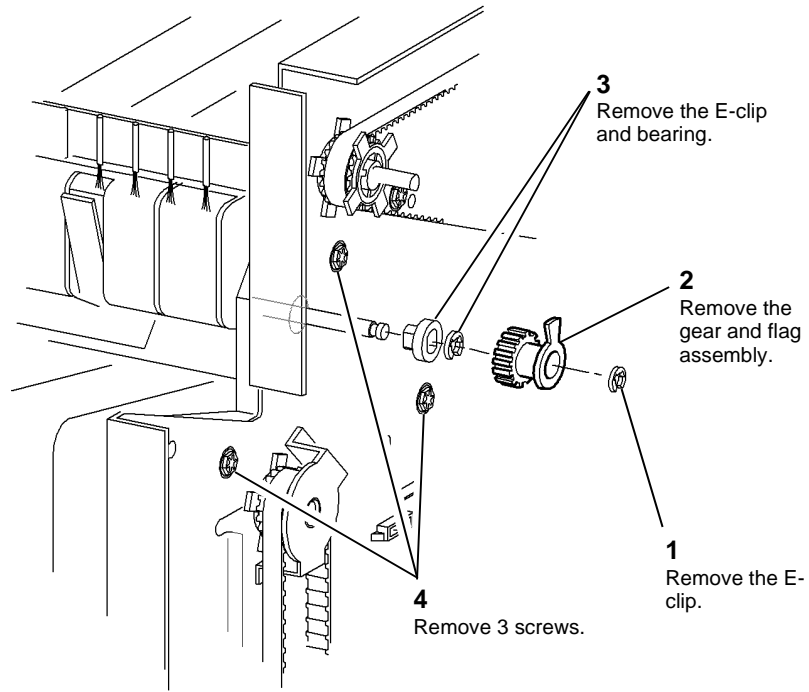
X-1-0311-A

4. Prepare to remove the rear components, [Figure 2](#).

Figure 2 Rear preparation

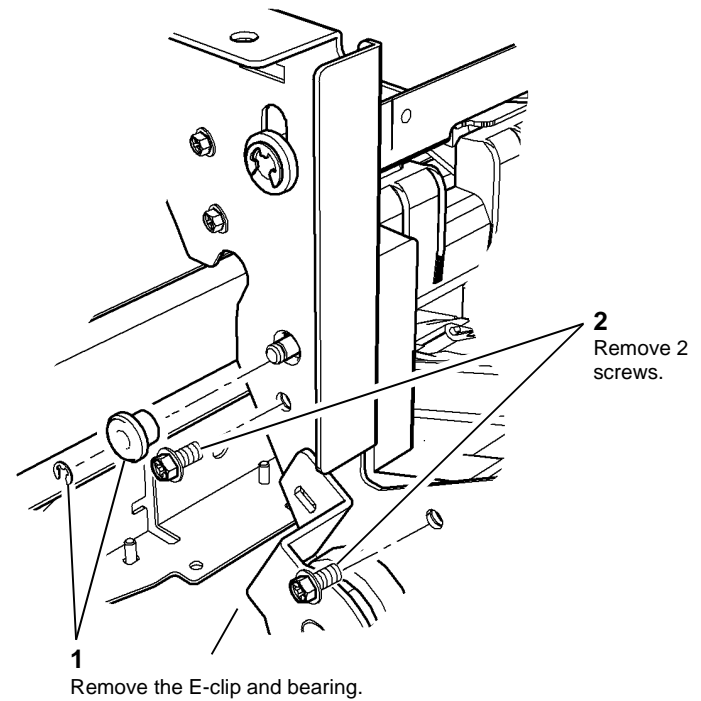
X-1-0312-A

5. Prepare to remove the front components, [Figure 3](#).

Figure 3 Front preparation

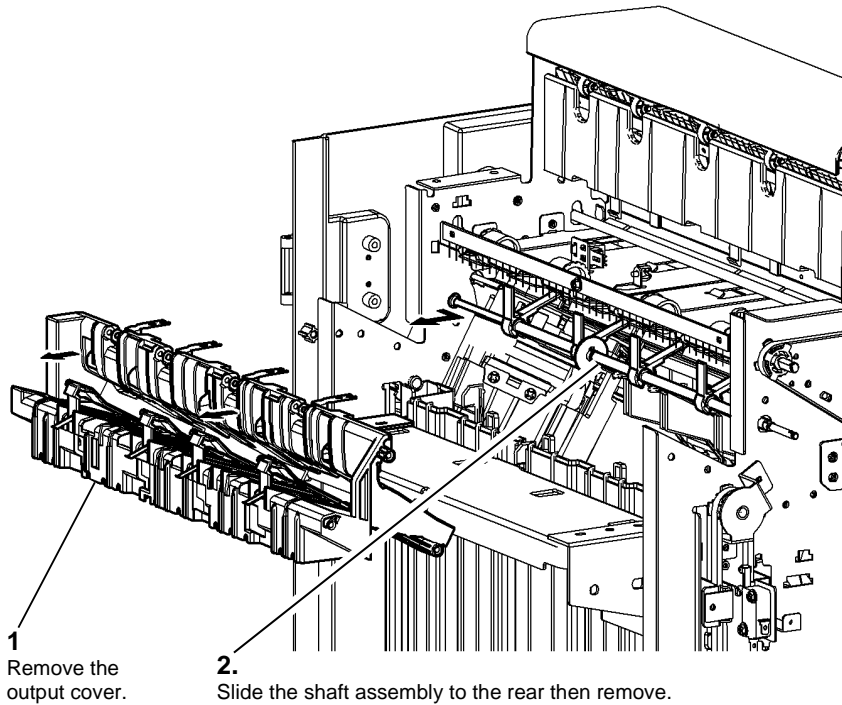
X-1-0313-A

- Remove the paddle shaft assembly, [Figure 4](#).

Figure 4 Paddle shaft removal

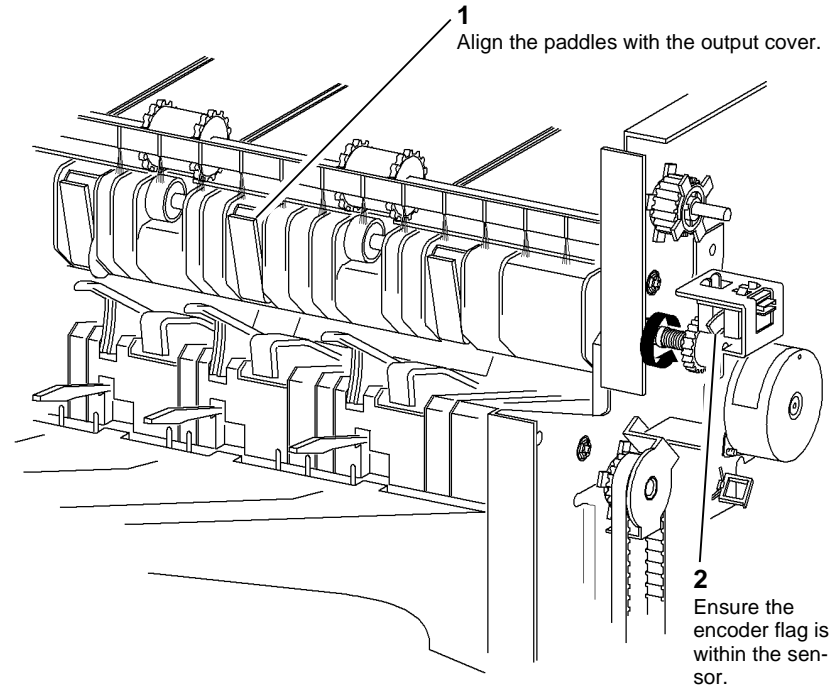
X-1-0314-A

- Ensure that the paddles and flag are correctly aligned [Figure 5](#).

Figure 5 Paddle alignment

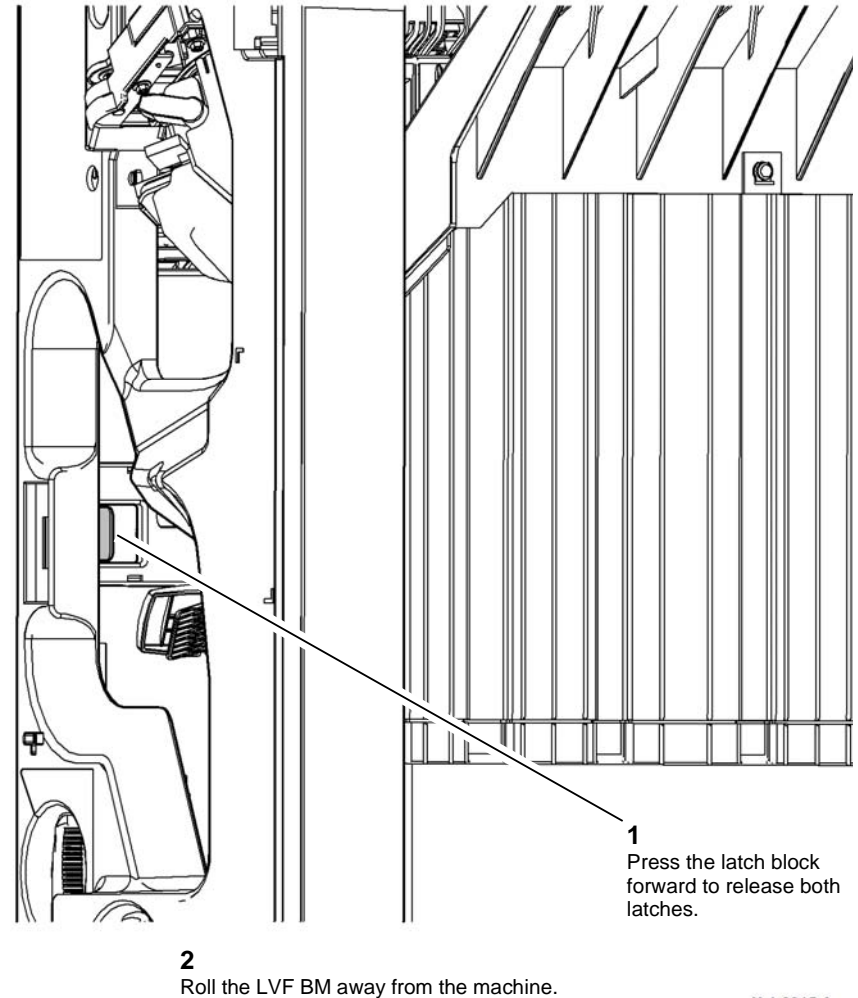
X-1-0315-A

3. Release the LVF BM link bracket assembly, [Figure 1](#).

Figure 1 LVF BM link bracket assembly

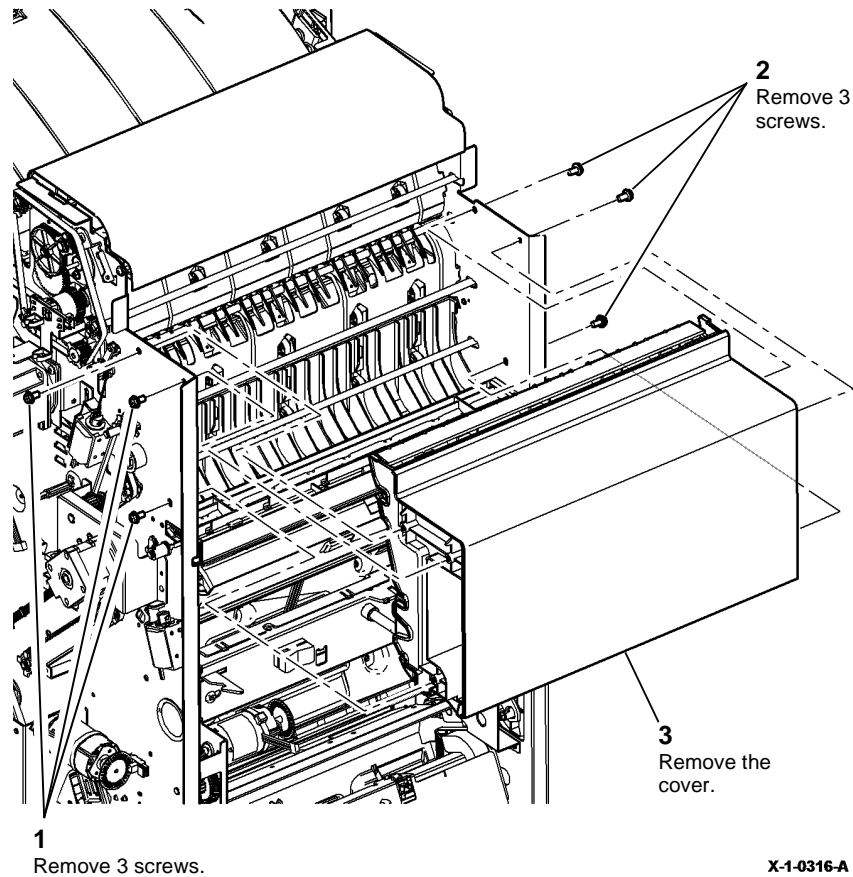
4. Remove the entry guide cover, [Figure 1](#).

Figure 1 Entry guide cover removal

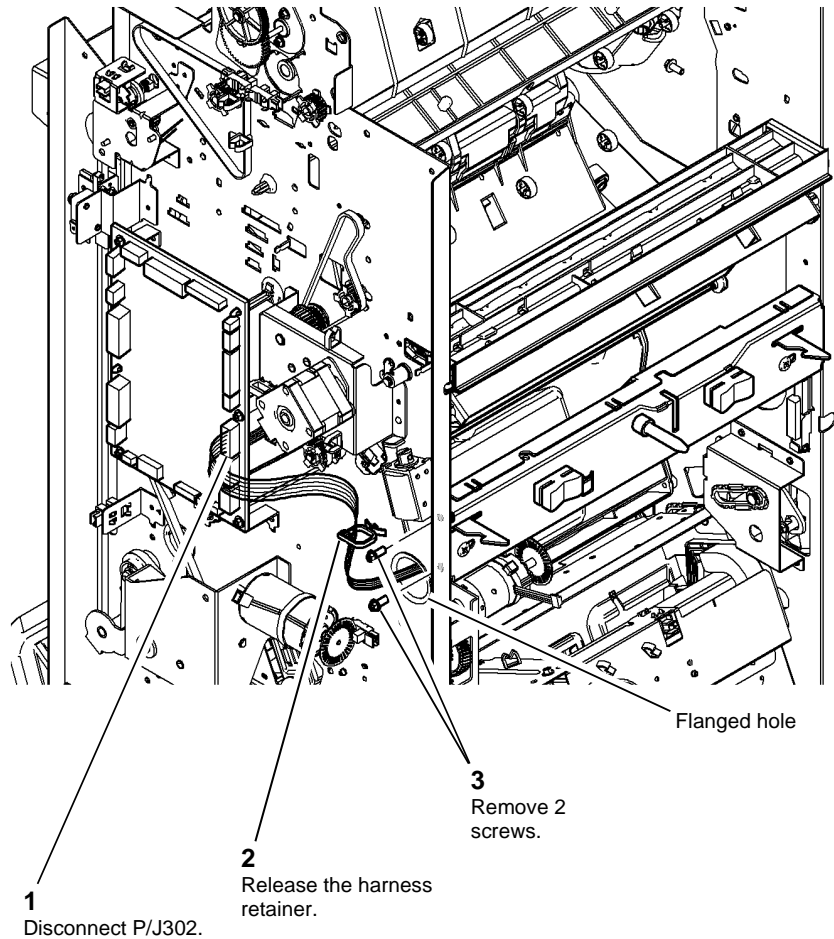
X-1-0317-A

3. Prepare to remove the docking latch assembly, **Figure 1**.

Figure 1 Prepare to remove the latch

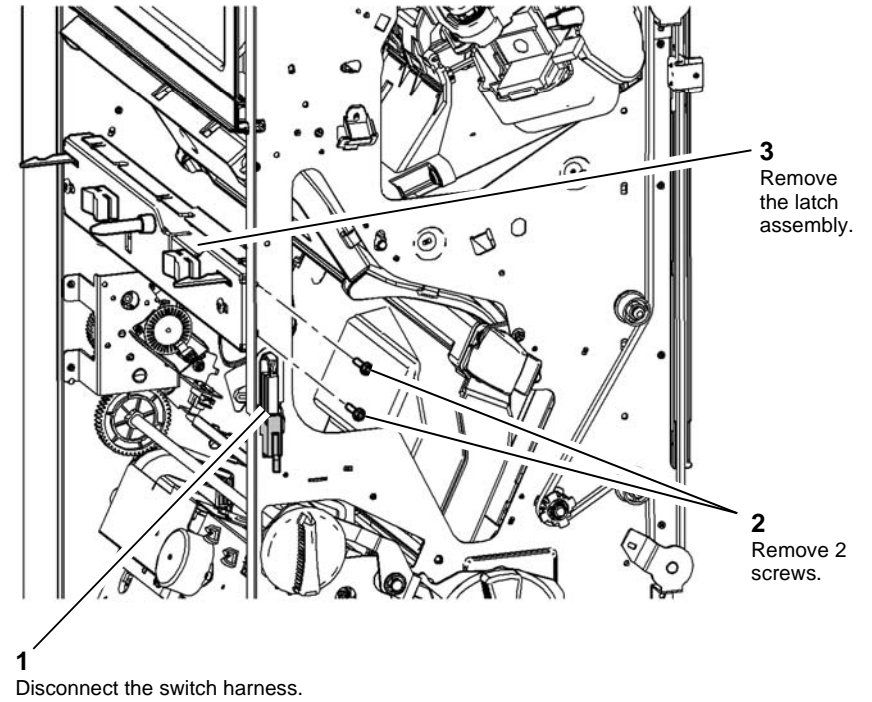
X-1-0318-A

4. Remove the docking latch assembly, **Figure 2**.

Figure 2 Latch assembly removal

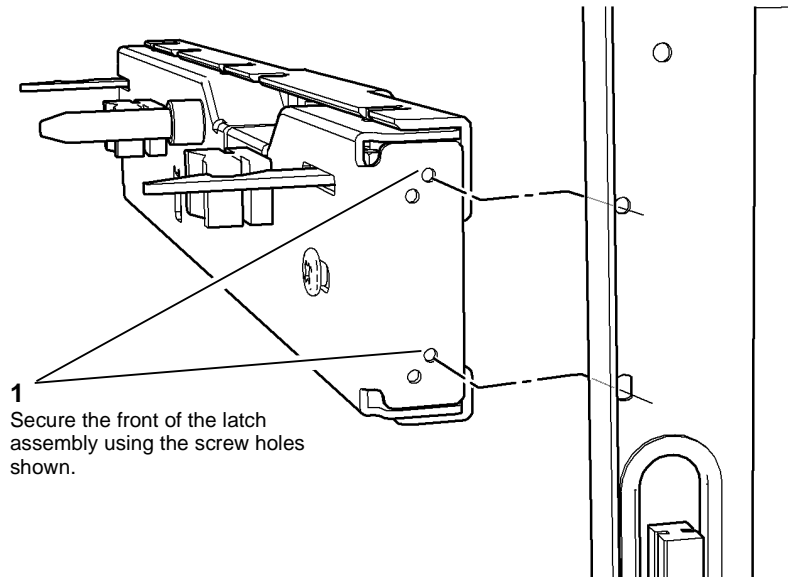
X-1-1322-A

1. The replacement is the reverse of the removal procedure.
2. Ensure the 2 screws at the front locate in the correct holes, [Figure 3](#).

1
Secure the front of the latch assembly using the screw holes shown.

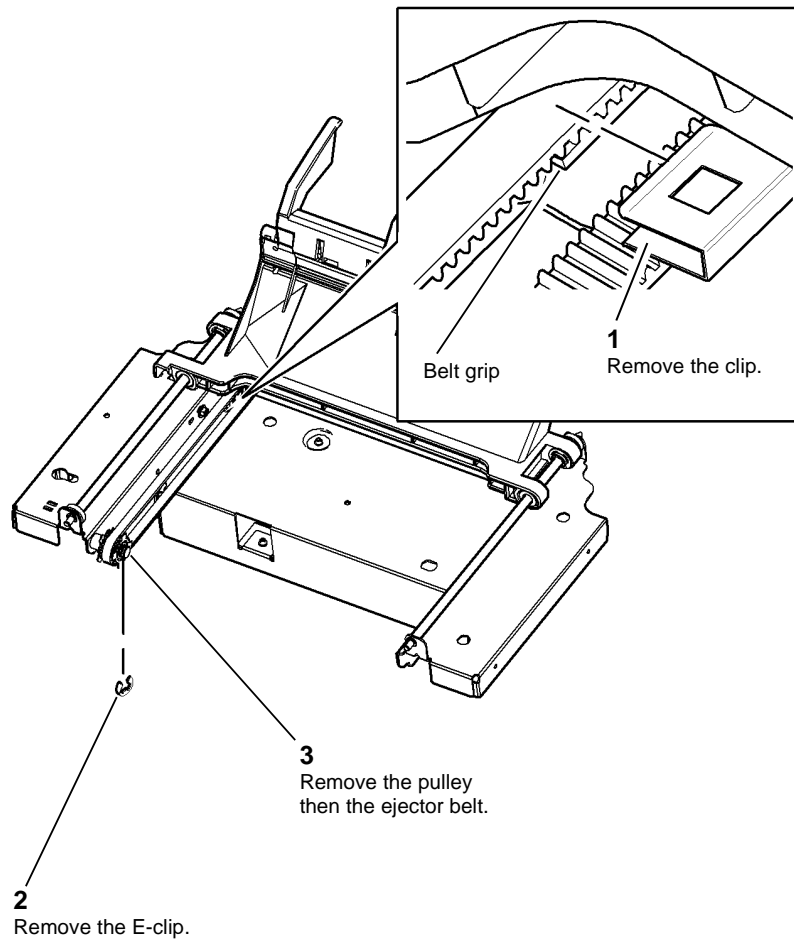
X-1-0319-A

- Remove the ejector belt, [Figure 1](#).

Figure 1 Remove the ejector belt

- The replacement is the reverse of the removal procedure.
- Ensure that the ejector belt is correctly engaged with the belt grip on the ejector assembly before the clip is re-installed. Refer to [Figure 1](#).

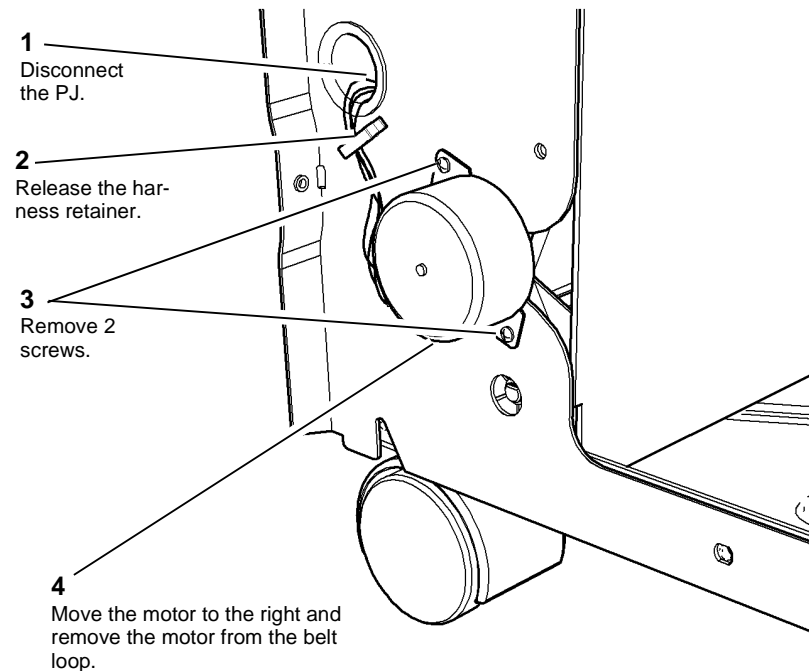
X-1-0320-A

- Un-dock the LVF BM, [REP 12.13-150](#).
- Remove the LVF BM front door cover assembly, [REP 12.1-150](#).
- Remove the back stop motor, [Figure 1](#).

Figure 1 Back stop motor removal

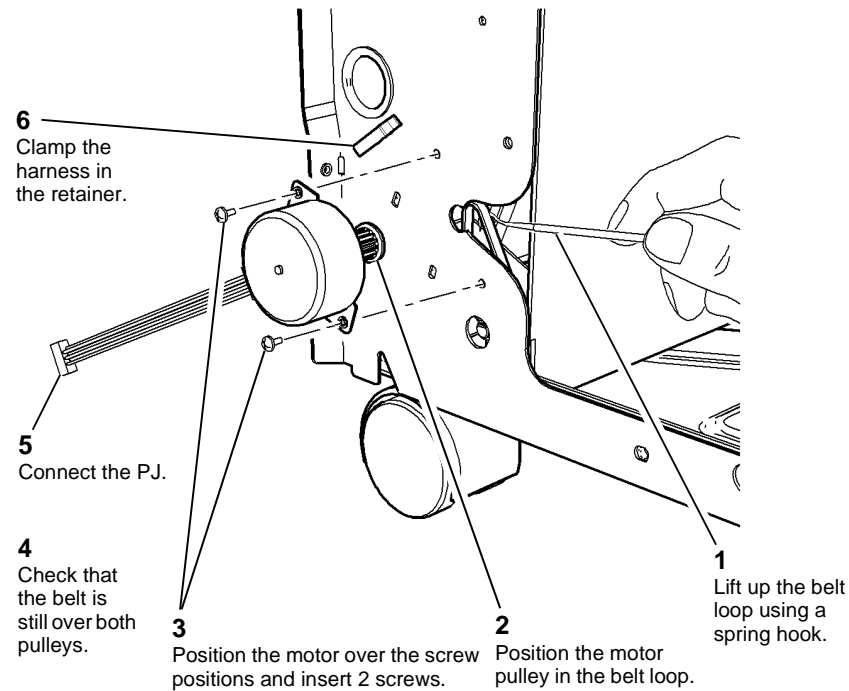
X-1-0321-A

1. Install the back stop motor, [Figure 2](#).

Figure 2 Back stop motor installation

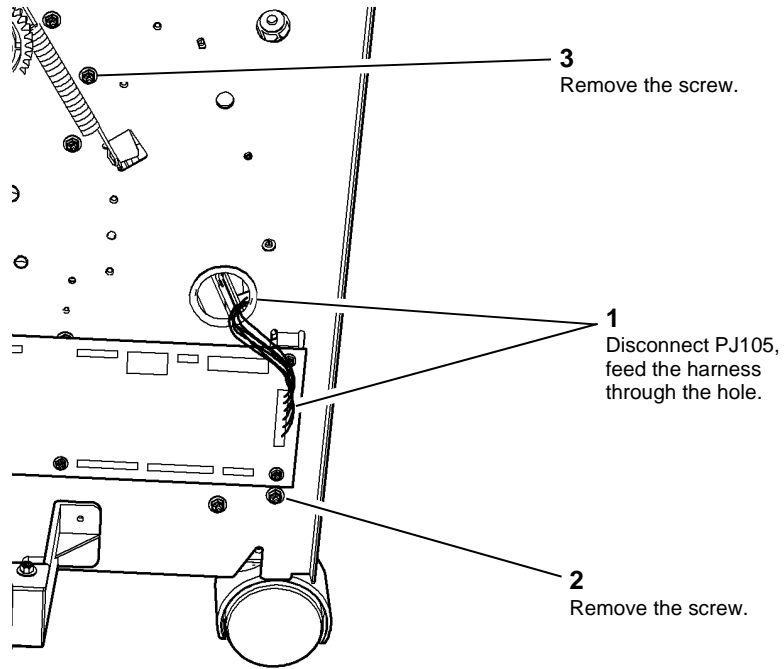
X-1-0322-A

6. Prepare to remove the left guide assembly, [Figure 1](#).

Figure 1 Preparation

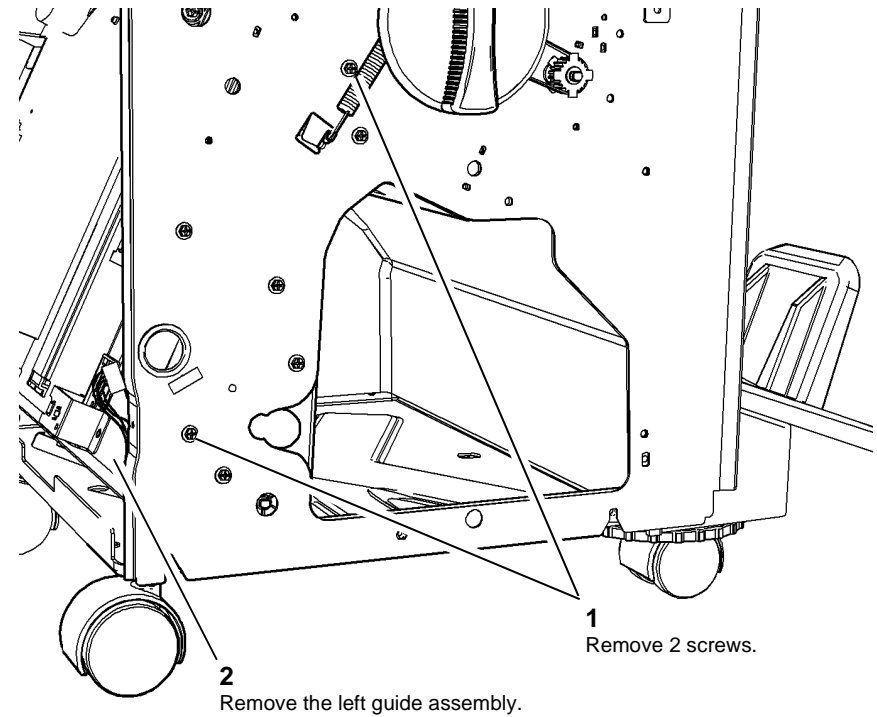
X-1-0323-A

7. Remove the left guide assembly, [Figure 2](#).

Figure 2 Left guide assembly removal

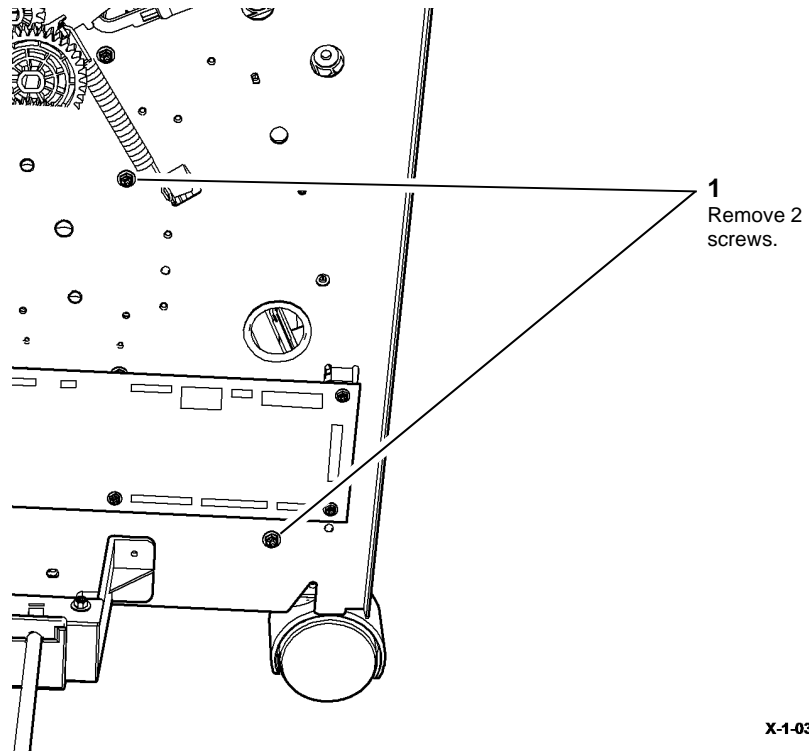
X-1-0324-A

9. Prepare to remove the right guide assembly, [Figure 3](#).

Figure 3 Preparation

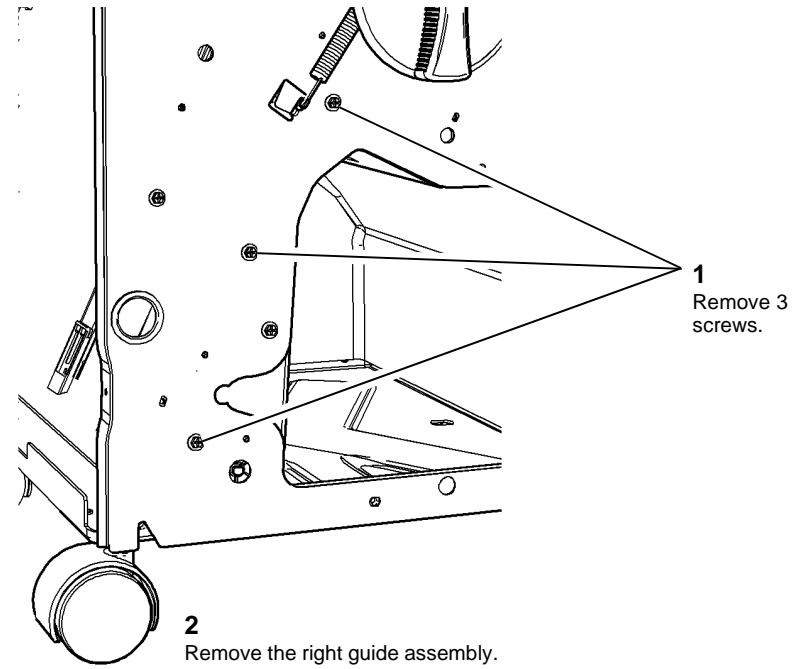
X-1-0325-A

10. Remove the right guide assembly, [Figure 4](#).

Figure 4 Right guide assembly removal

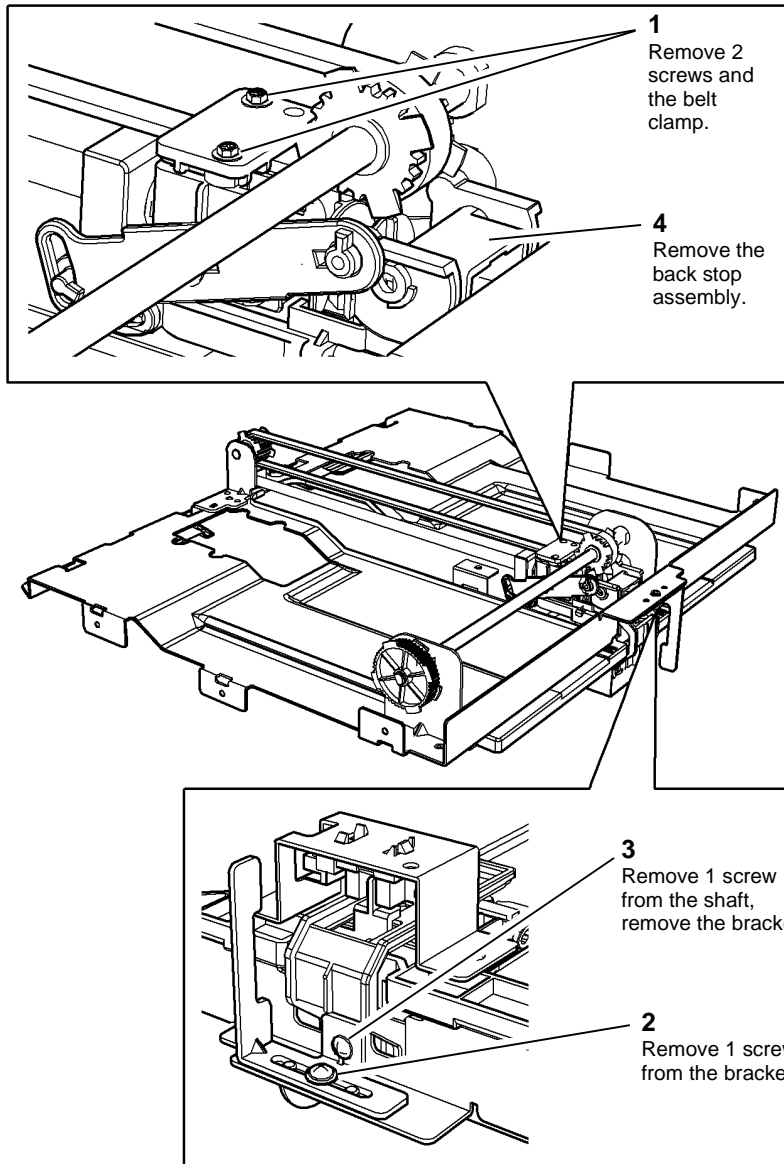
X-1-0326-A

11. Remove the back stop assembly, [Figure 5](#).

Figure 5 Back stop assembly removal

1. Refer to [GP 6](#) before refitting the screws.
2. Install the back stop assembly by reversing the steps in [Figure 5](#). Ensure that the back stop is correctly located, [Figure 6](#). Ensure that the belt clamp is correctly located, [Figure 7](#).

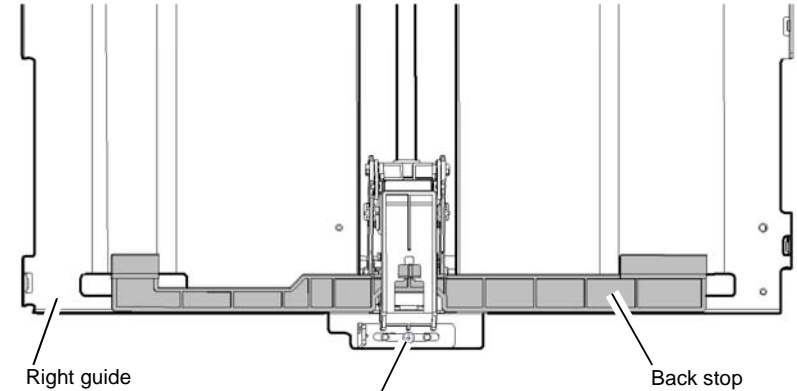
X-1-0327-A

- 1** Move the back stop to align the bottom edge with the bottom edge of the right guide.
- 2** Align the back stop so that the inboard and outboard lower edges are in-line with the bottom edge of the right guide.
- 3** Tighten the screw.

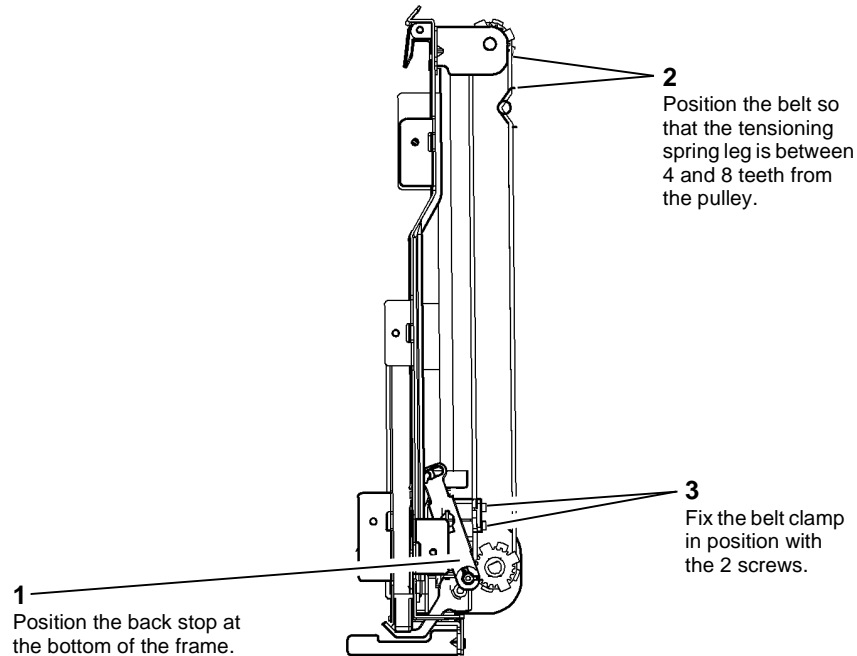
X-1-0328-A

Figure 7 Belt clamp location

3. Manually move the back stop to both extremes of travel. Ensure that the tensioner spring does not touch either pulley. If necessary re-position the belt clamp.
4. Reverse the removal procedure to install the remainder of the removed components.
5. If a new sub plate, [PL 12.400 Item 16](#) with static eliminator, [PL 12.400 Item 17](#) attached is being installed, un-clip the old sub plate, clip on the new sub plate.
6. If new static eliminators, [PL 12.400 Item 15](#) are being installed, peel off the old static eliminators, then peel the backing paper from the new static eliminators and apply to the left guide assembly, press firmly in place.
7. Perform [ADJ 12.8-150 Booklet Skew](#).
8. Perform [ADJ 12.4-150 Booklet Crease Position](#).

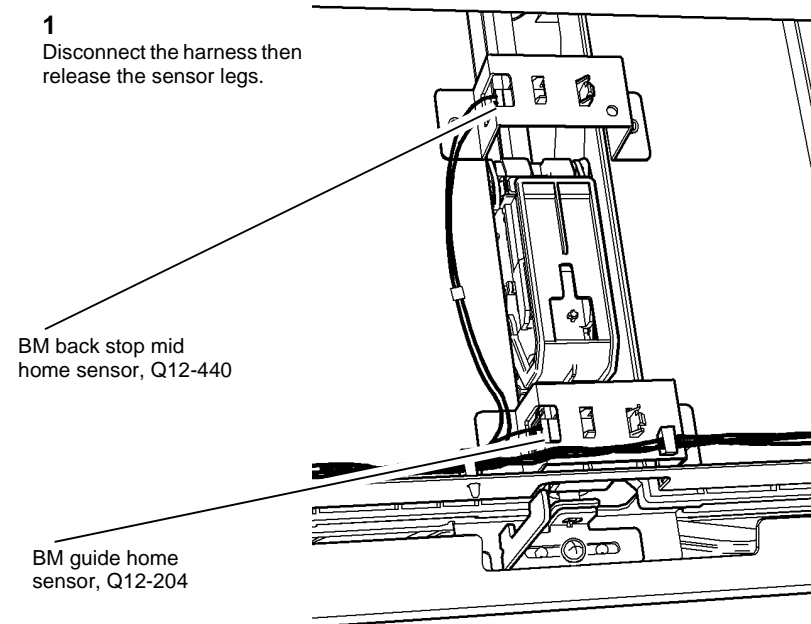
X-1-0329-A

1. Un-dock the LVF BM, [REP 12.13-150](#).
2. Remove the LVF BM back stop cover, [REP 12.1-150](#).
3. Remove the sensors, [Figure 1](#).

Figure 1 Sensors removal

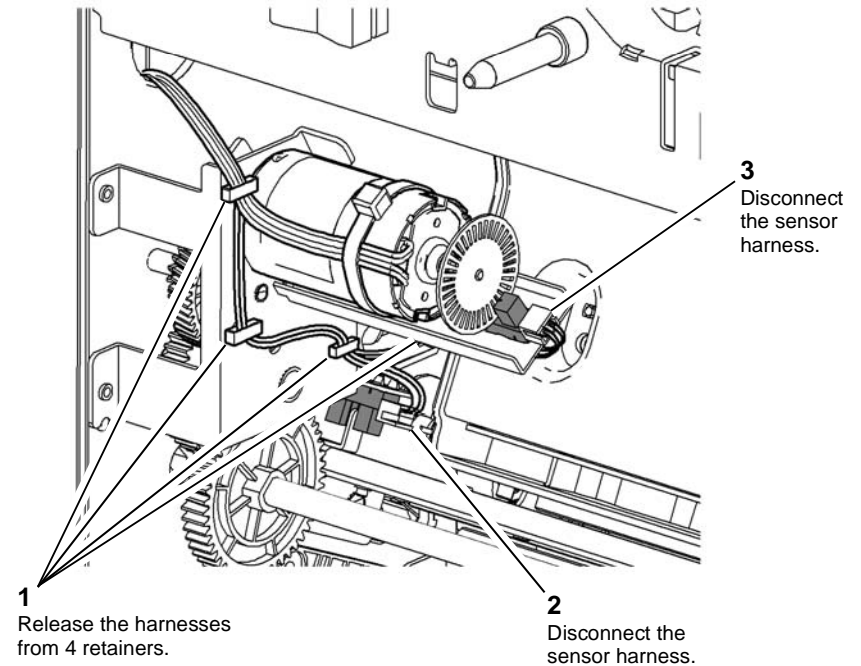
X-1-0330-A

3. Prepare to remove the crease blade motor and gearbox, Figure 1.

Figure 1 Preparation
