708P91368
September 2017

Xerox® AltaLink® B8090 Family Multifunction Printer Service Manual

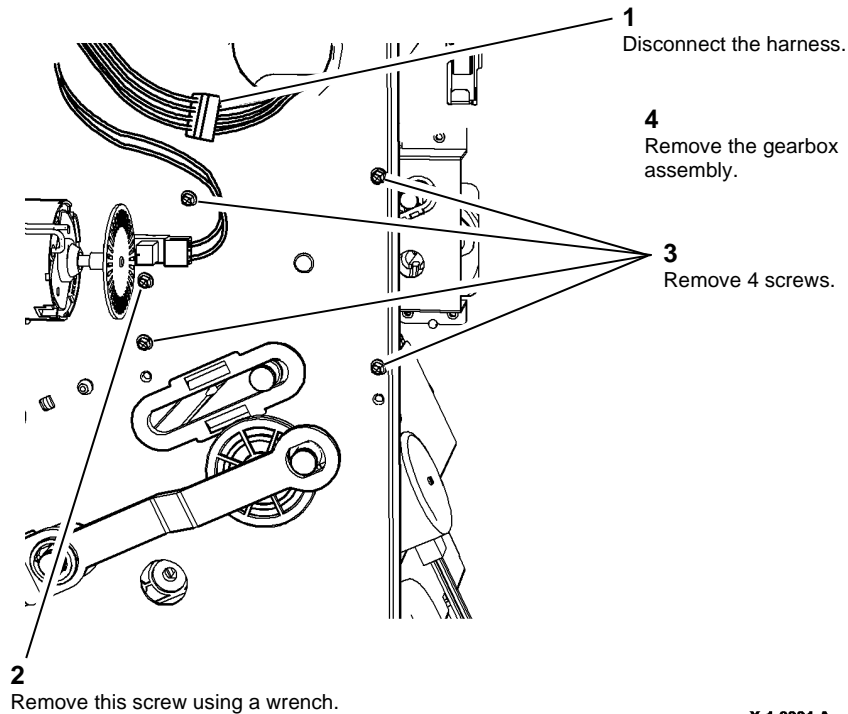
X-1-0331-A

- Remove the crease blade gearbox assembly, [Figure 2](#).

Figure 2 Gearbox assembly removal

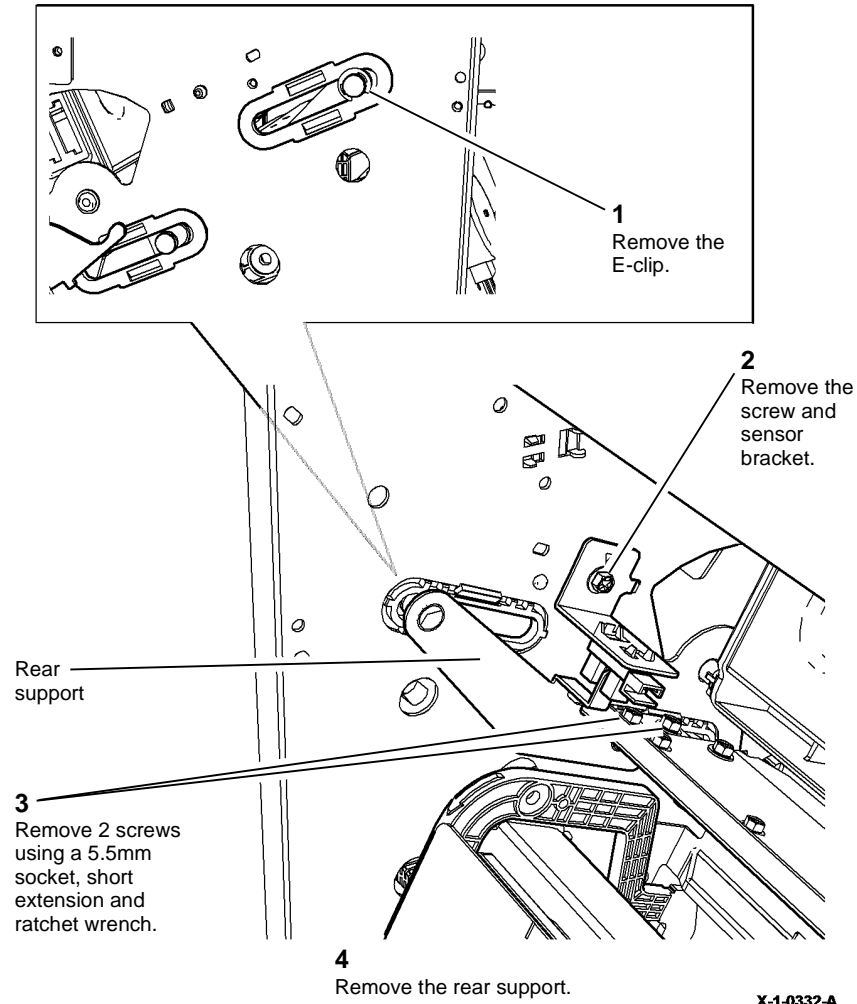
5. Prepare to remove the crease blade assembly, **Figure 1**.

Figure 1 Preparation

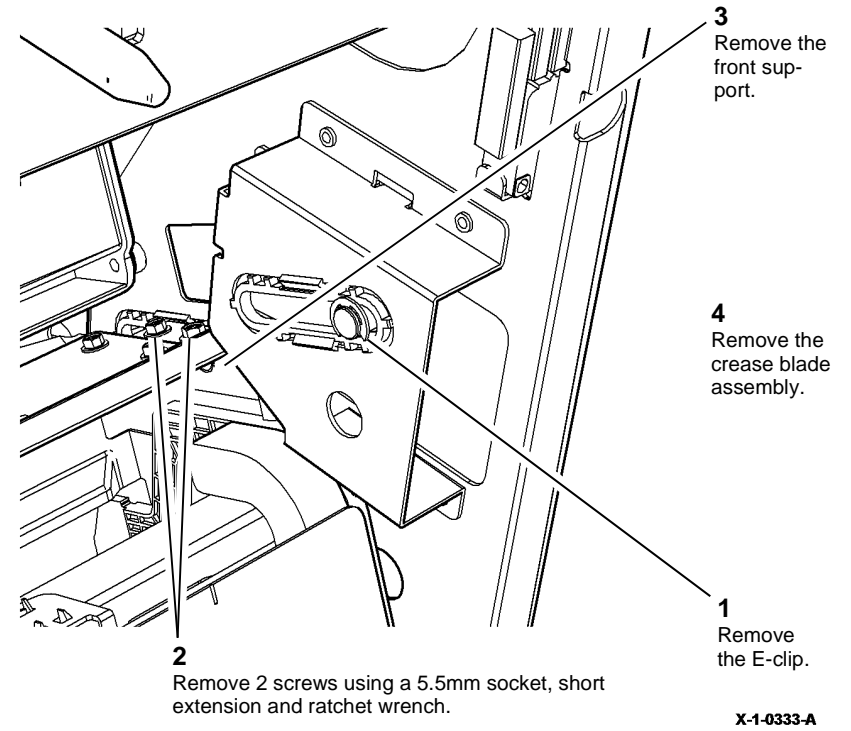
6. Remove the crease blade assembly, **Figure 2**.

Figure 2 Crease blade assembly removal

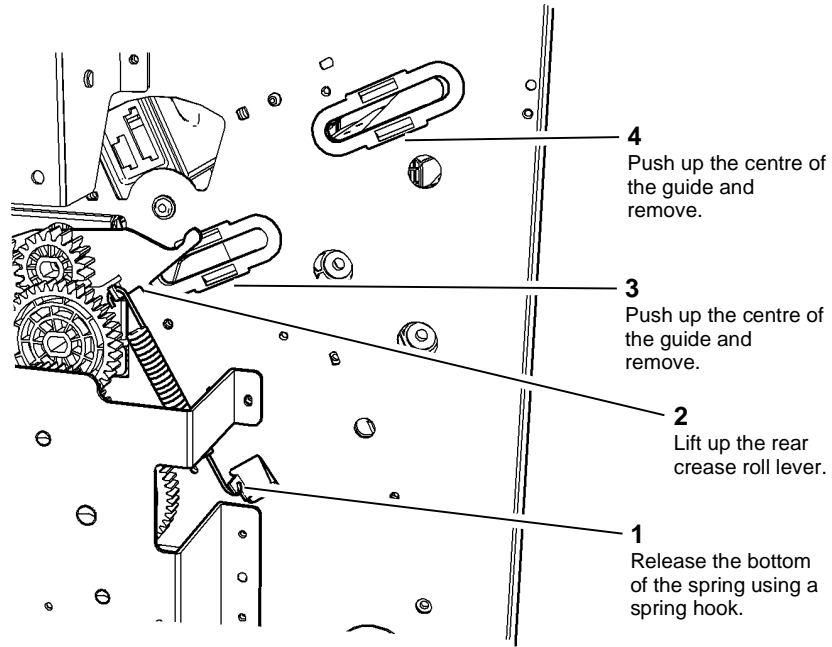
X-1-0334-A

7. Remove the rear crease blade guides, [Figure 3](#).

Figure 3 Rear guides removal

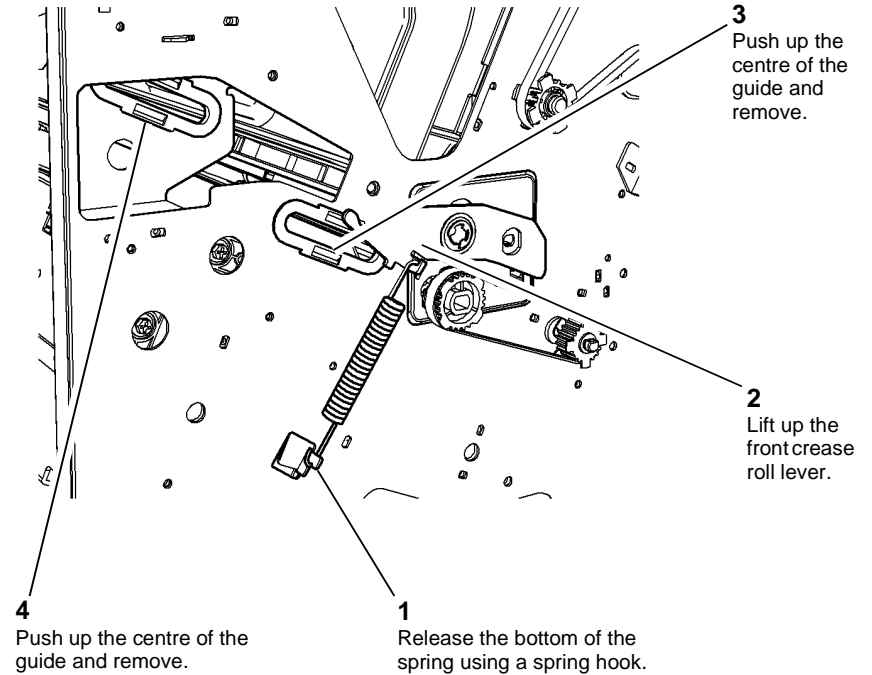
X-1-0335-A

8. Remove the front crease blade guides, [Figure 4](#).

Figure 4 Front guides removal

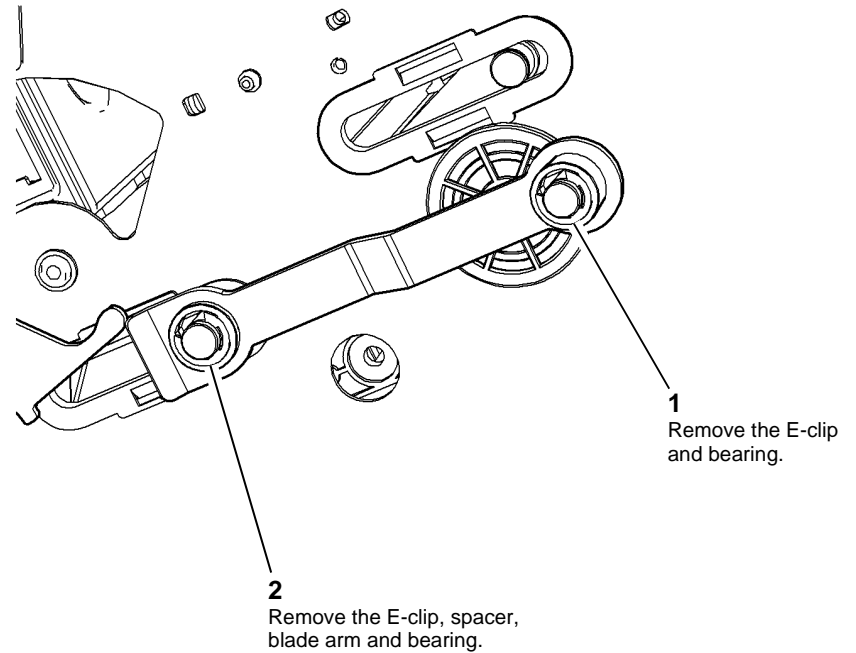
X-1-0336-A

1. Un-dock the LVF BM, [REP 12.13-150](#).
2. Remove the LVF BM front door cover assembly and rear cover, [REP 12.1-150](#).
3. Remove the crease blade gearbox assembly, [REP 12.21-150](#).
4. Remove the rear blade arm, [Figure 1](#).

Figure 1 Rear blade arm removal

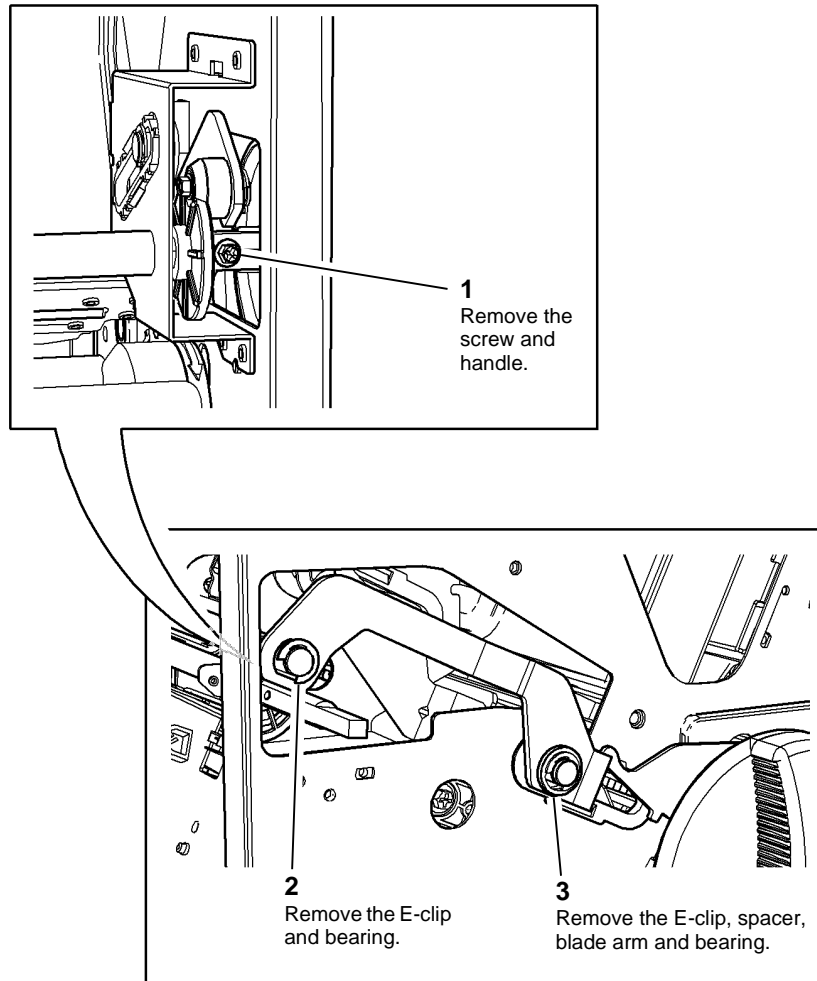
X-1-0337-A

5. Remove the front blade arm, [Figure 2](#).

Figure 2 Front blade arm removal

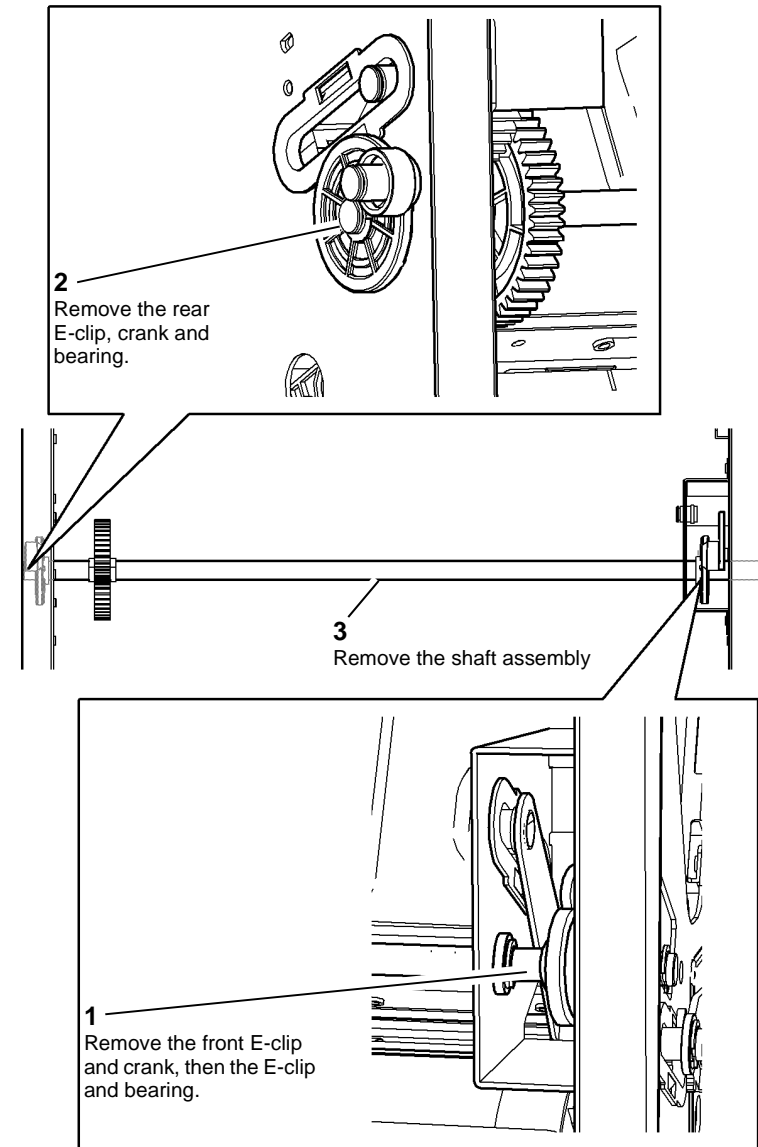
X-1-0338-A

6. Remove the crease blade shaft assembly, [Figure 3](#).

Figure 3 Crease blade shaft removal

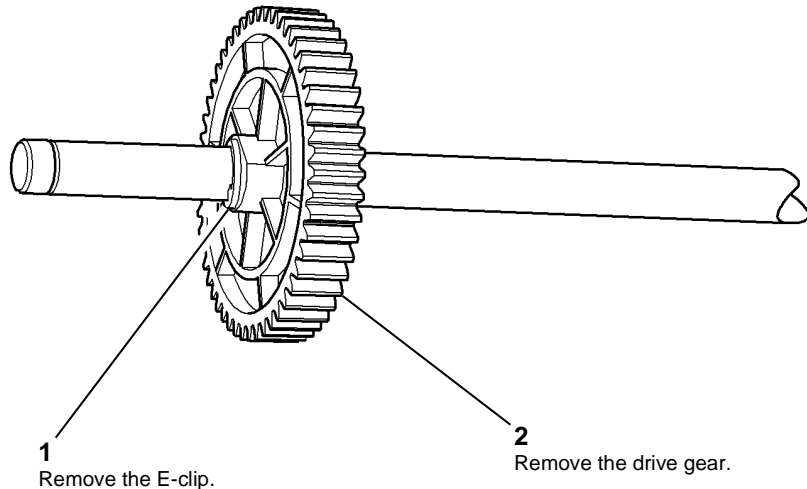
X-1-0339-A

7. Remove the crease blade drive gear, [Figure 4](#).

Figure 4 Drive gear removal

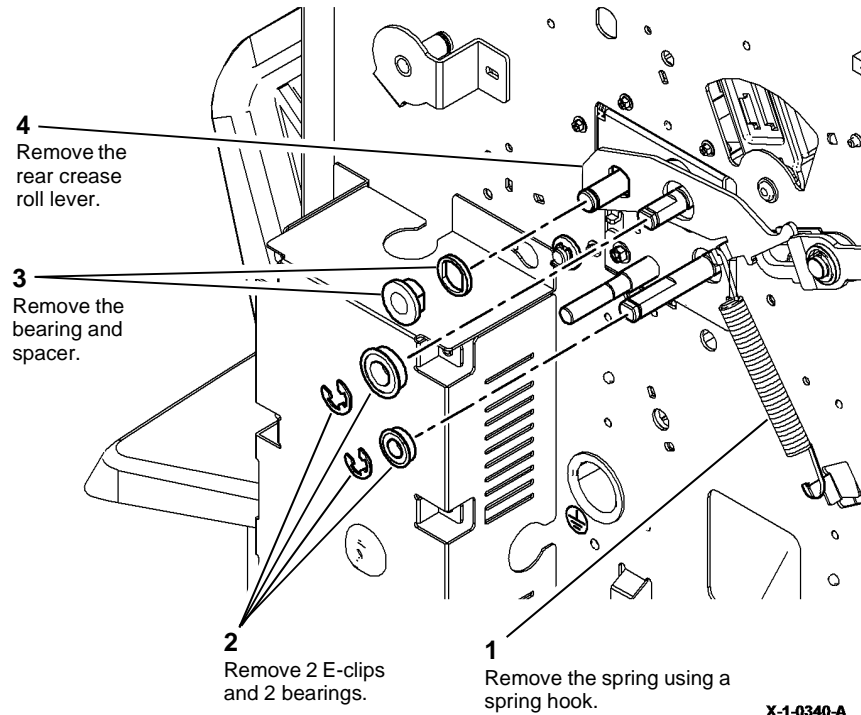
5. Remove the rear crease roll lever, [Figure 1](#).

Figure 1 Rear lever removal

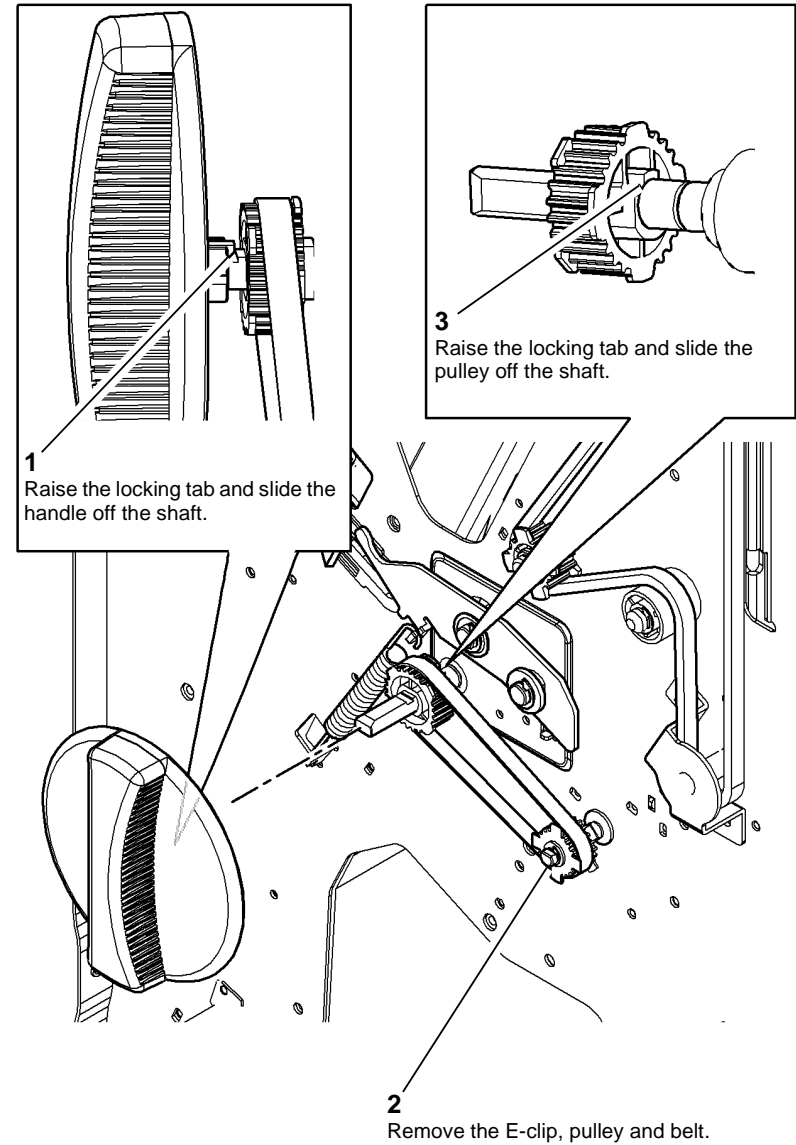
6. Remove the exit roll belt components, [Figure 2](#).

Figure 2 Exit roll belt removal

1. The replacement is the reverse of the removal procedure.
2. When replacing the exit roll belt components, ensure the one-way clutch on the pulley is on the inside. Refer to [Figure 2](#).

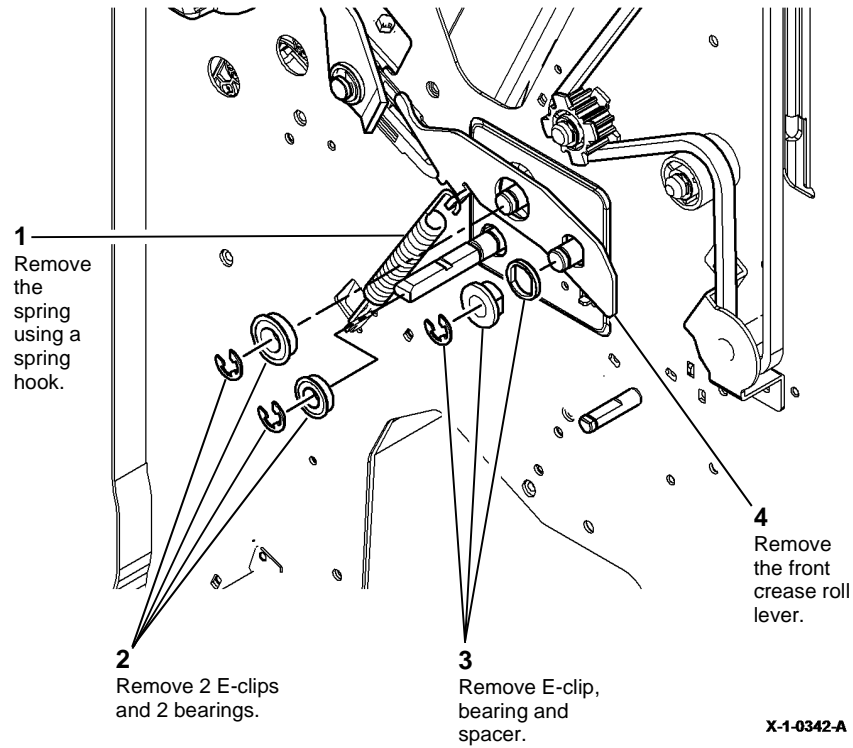
7. Remove the front crease roll lever, [Figure 3](#).

Figure 3 Front lever removal

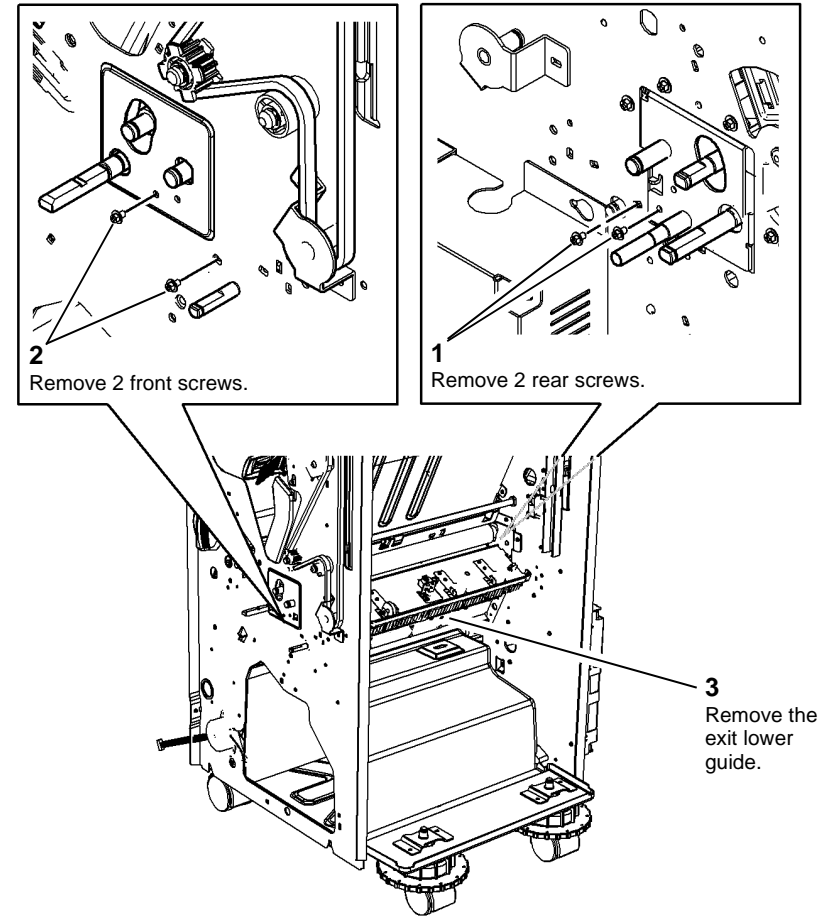
12. Remove the exit lower guide, [Figure 4](#).

Figure 4 Exit lower guide removal

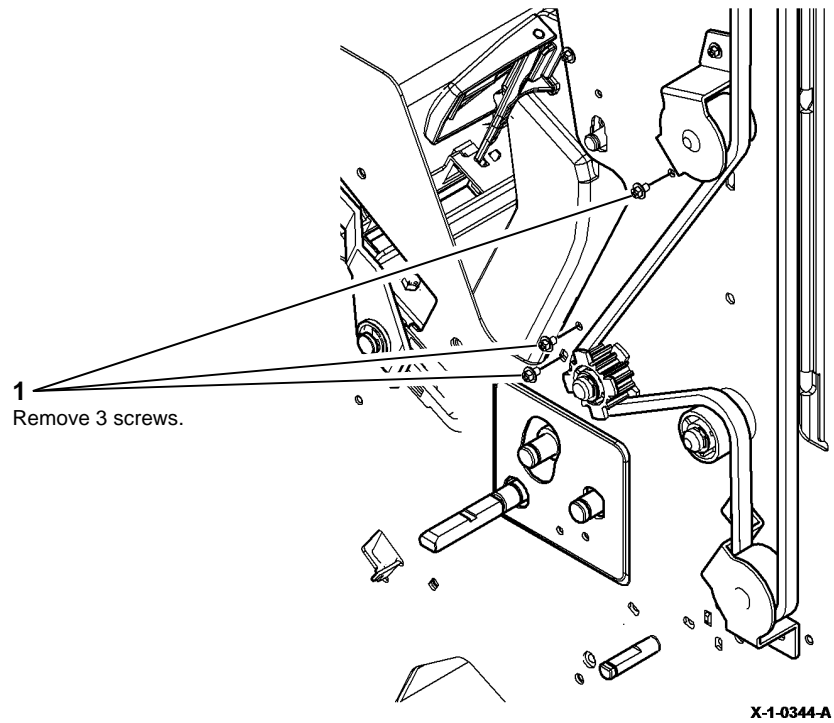
14. Prepare to release the booklet compiler tray, [Figure 5](#).

Figure 5 Preparation

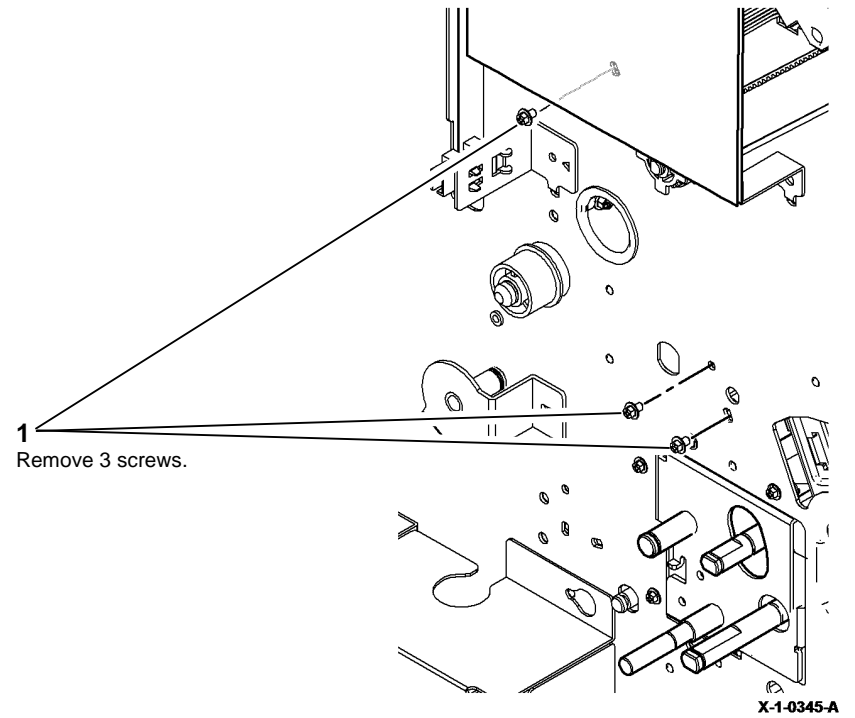
15. Release the booklet compiler tray, [Figure 6](#).

Figure 6 Tray release

NOTE: The lifted booklet compiler tray can be temporarily supported by loosely holding it in place with a screw. Lift the tray as high as it can be raised. Align the lower screw hole with a suitable hole in the finisher frame.

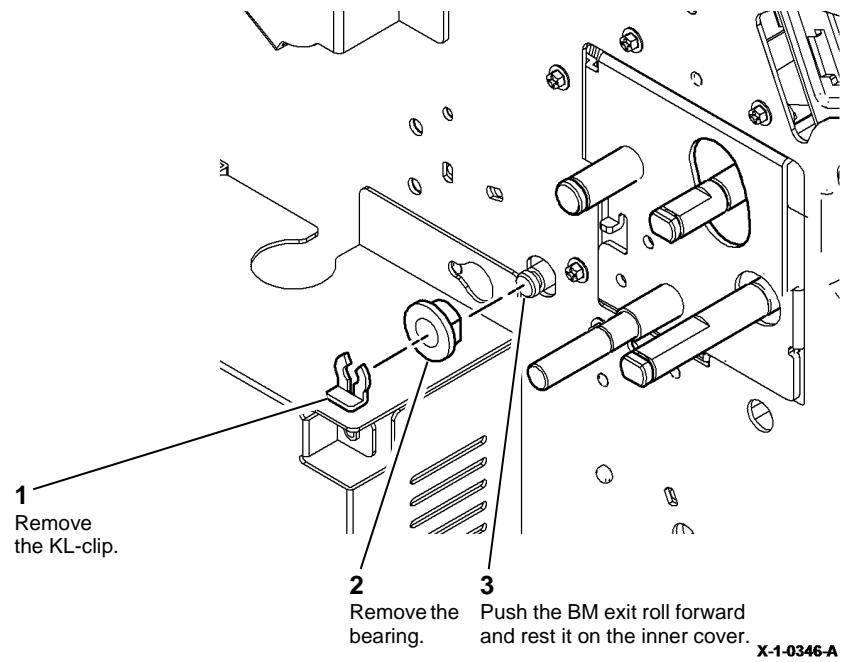
16. Release the rear of the BM exit roll assembly, [Figure 7](#).

Figure 7 BM exit roll release

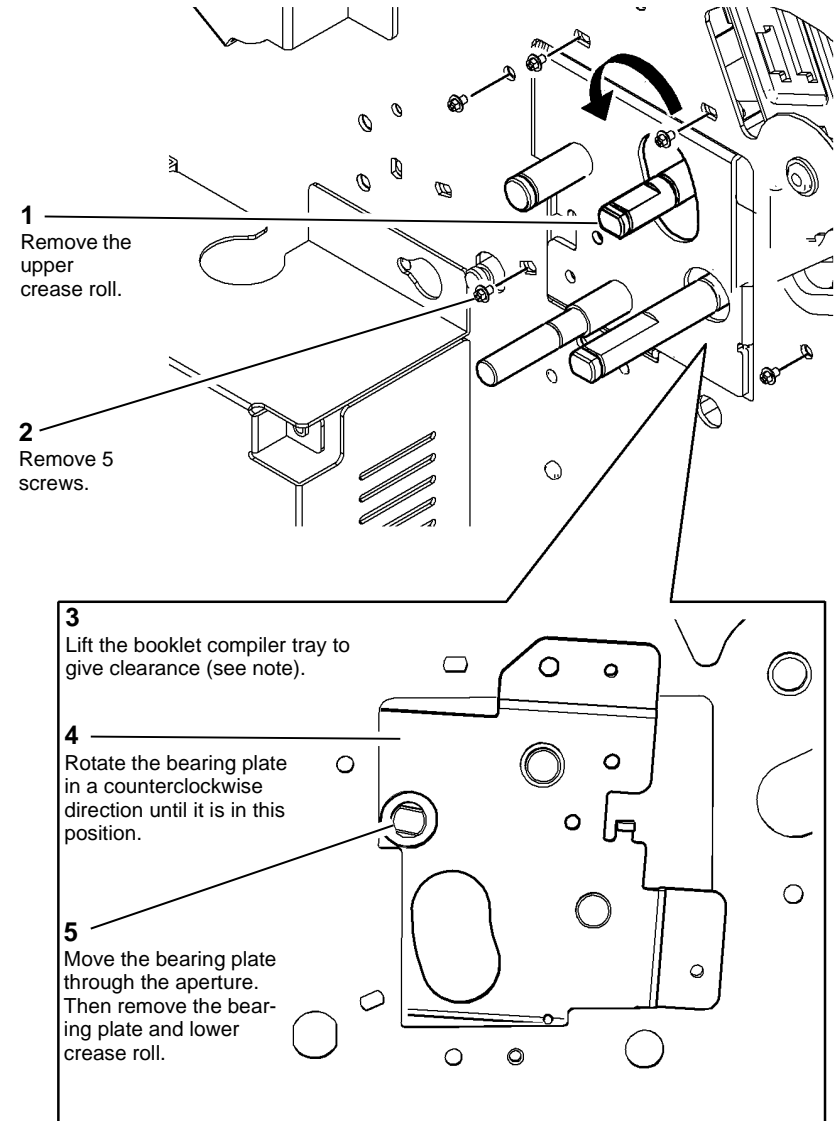
17. Remove the upper and lower crease roll, [Figure 8](#).

Figure 8 Crease rolls removal

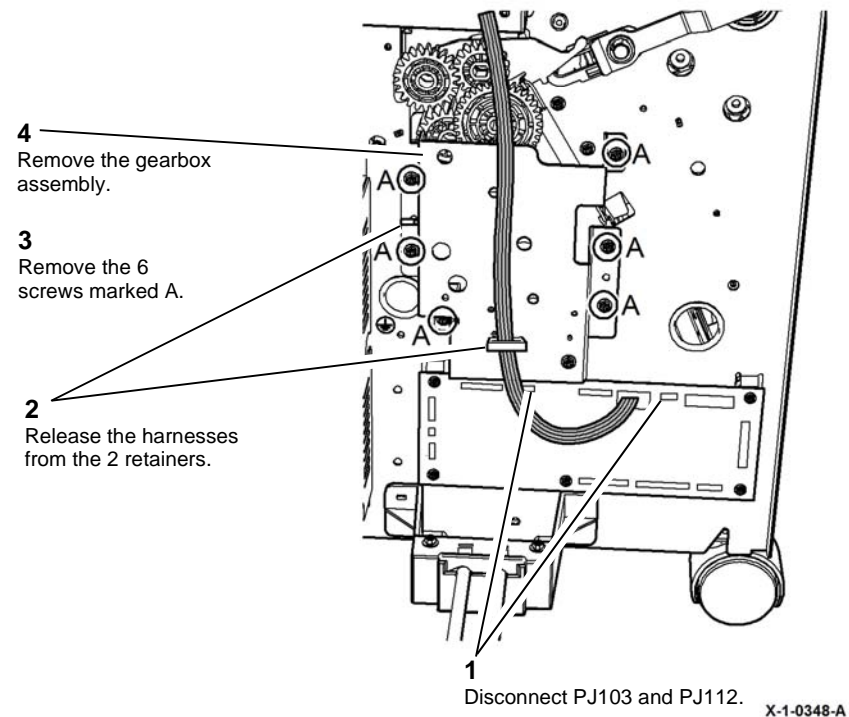
1. Remove the LVF BM top and rear covers, [REP 12.1-150](#).
2. Remove the crease roll gearbox assembly, [Figure 1](#).

Figure 1 Gearbox removal

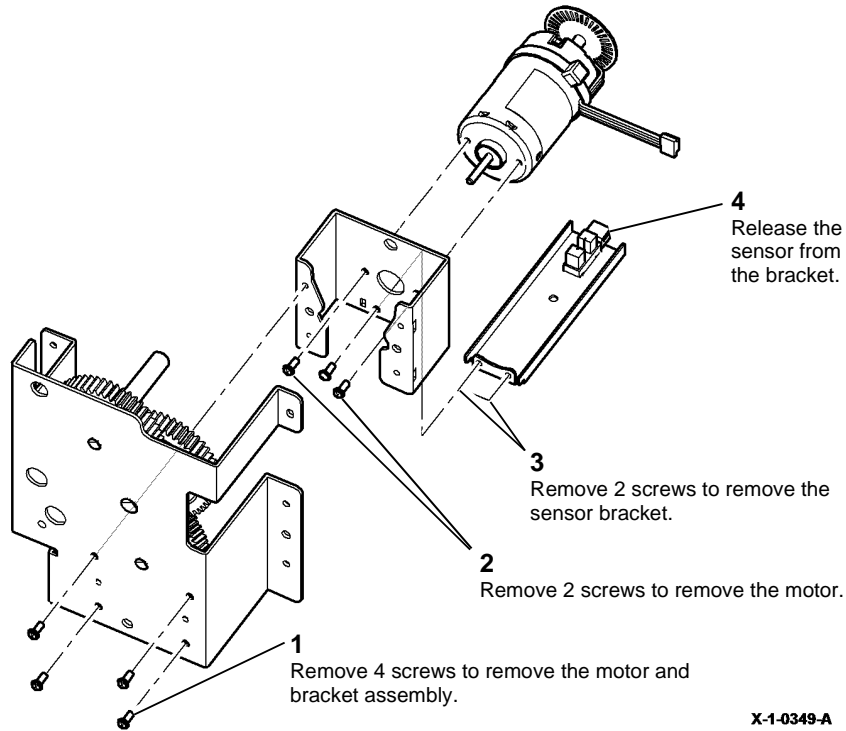
X-1-0349-A

- Remove the crease roll motor and sensor, [Figure 2](#).

Figure 2 Crease roll motor removal

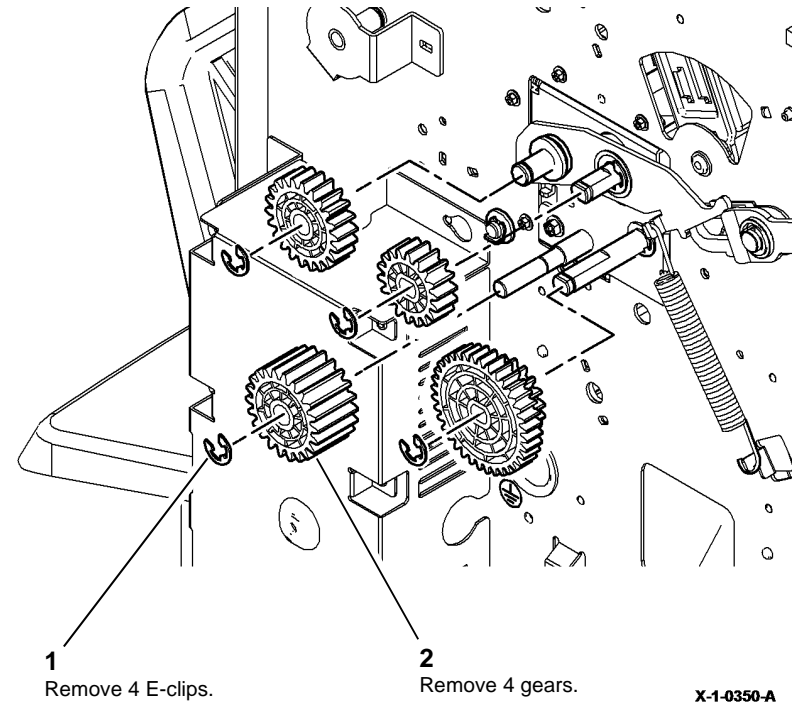
X-1-0350-A

- Remove the crease roll motor and gearbox, [REP 12.25-150](#).
- Remove the crease roll gears, [Figure 1](#).

Figure 1 Gears removal

- Ensure the gears are located in their correct positions. Refer to [Figure 1](#).
- Reverse the removal procedure to replace the remainder of the components.

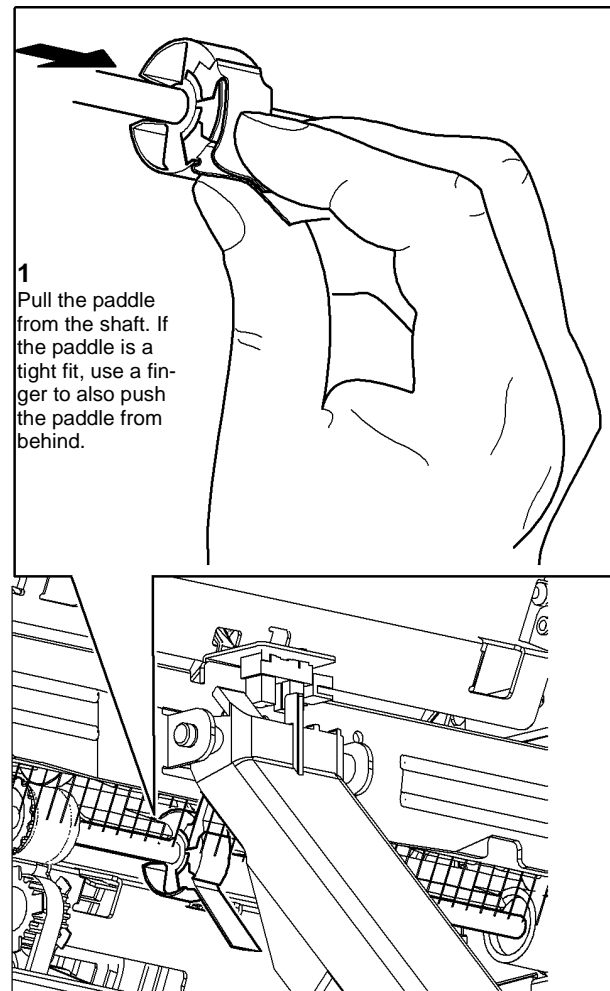
X-1-0351-A

3. Remove the exit roll paddle, [Figure 1](#).

Figure 1 Exit roll paddle removal

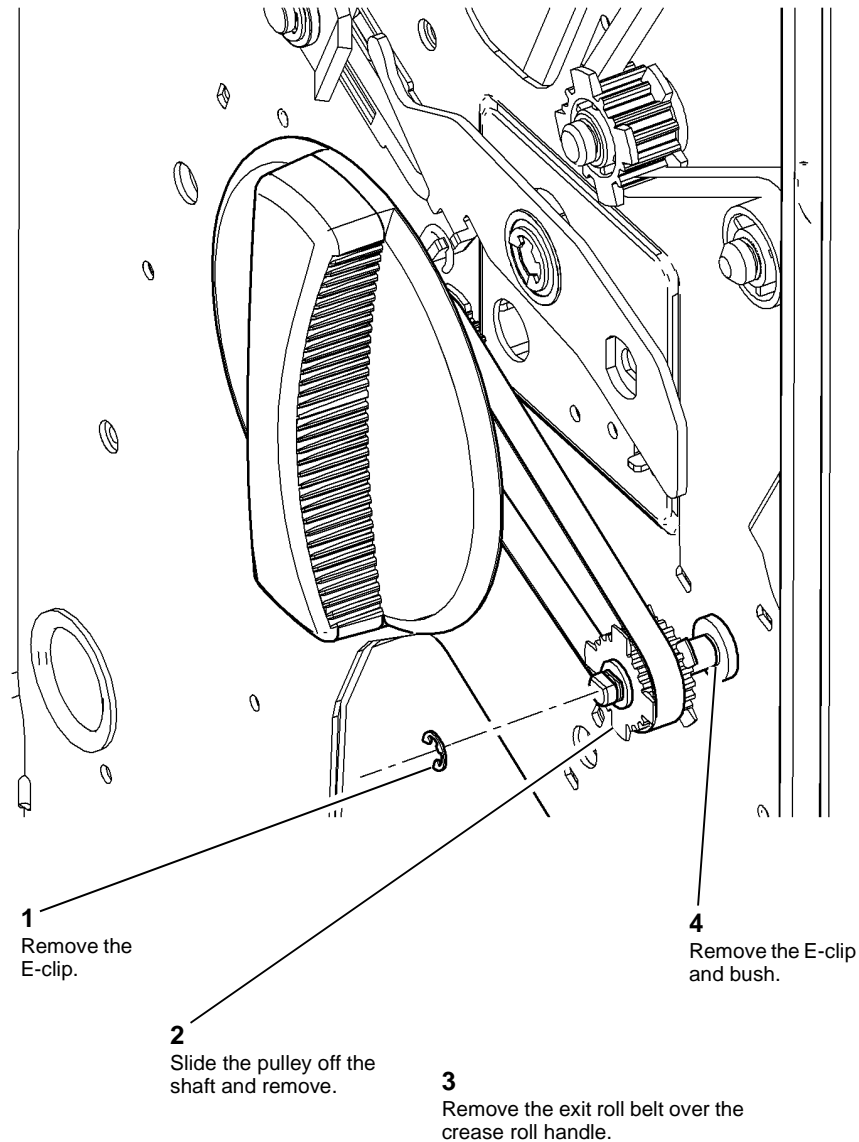
X-1-0352-A

4. Remove the belt pulley and bush, [Figure 2](#).

Figure 2 Belt pulley and bush removal

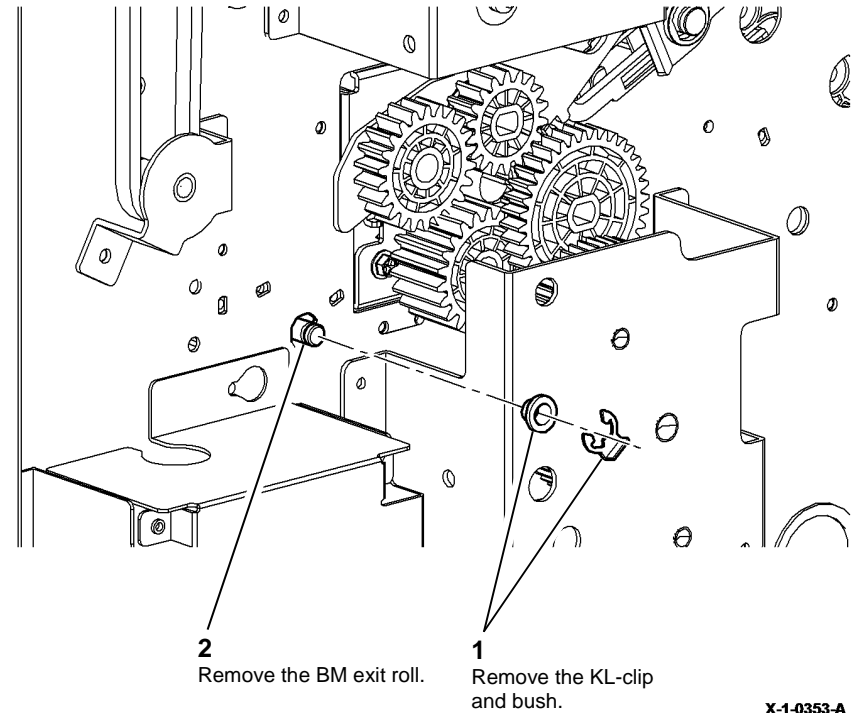
X-1-0353-A

5. Remove the BM exit roll, [Figure 3](#).

Figure 3 BM exit roll removal

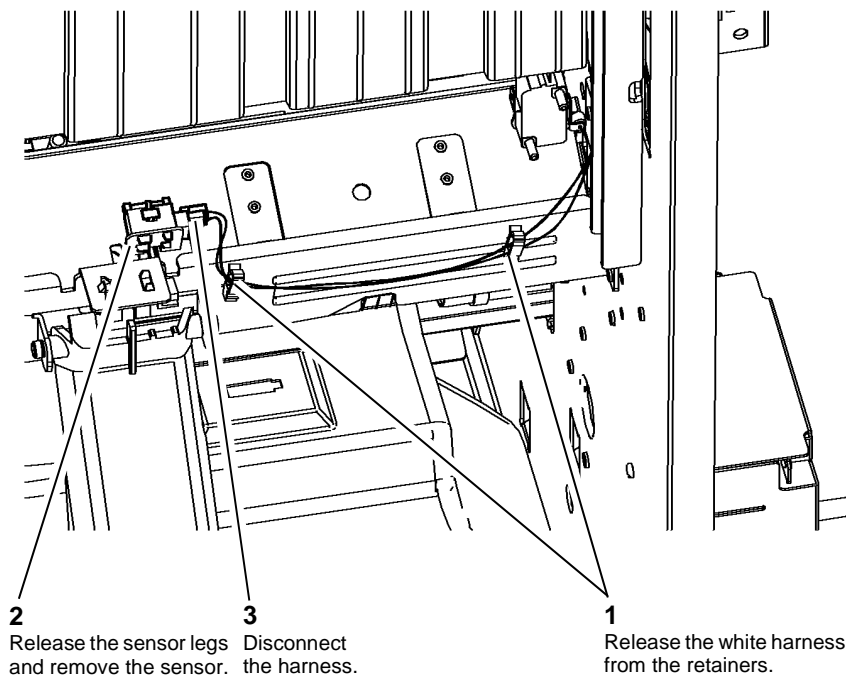
X-1-0354-A

1. Remove the lower right cover, [REP 12.45-150](#).
2. Remove the BM exit sensor, [Figure 1](#).

Figure 1 BM exit sensor removal

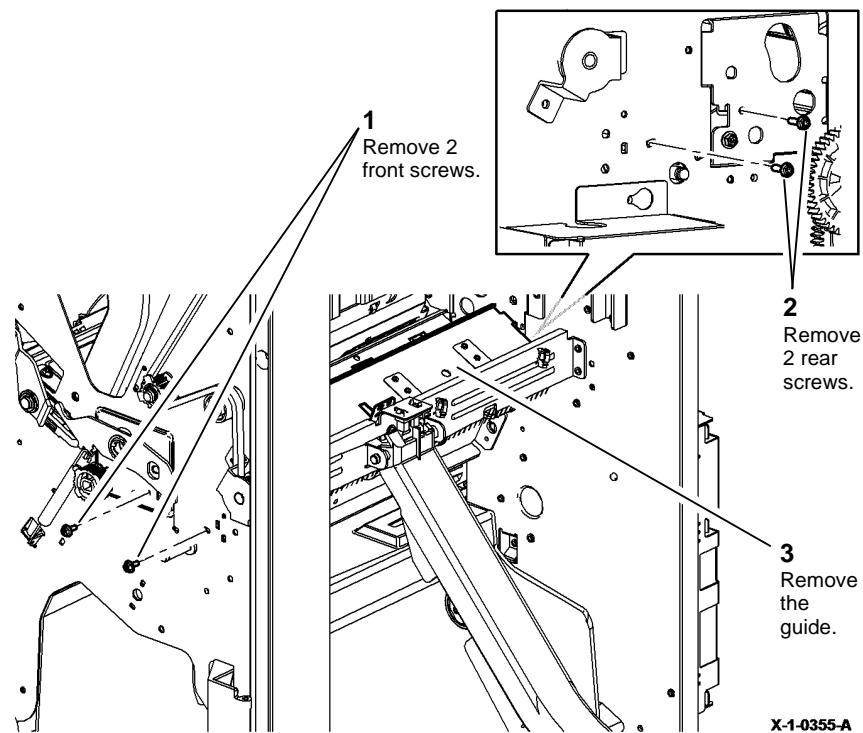
X-1-0355-A

3. Remove the BM exit upper guide assembly, [Figure 2](#).

Figure 2 Upper guide removal

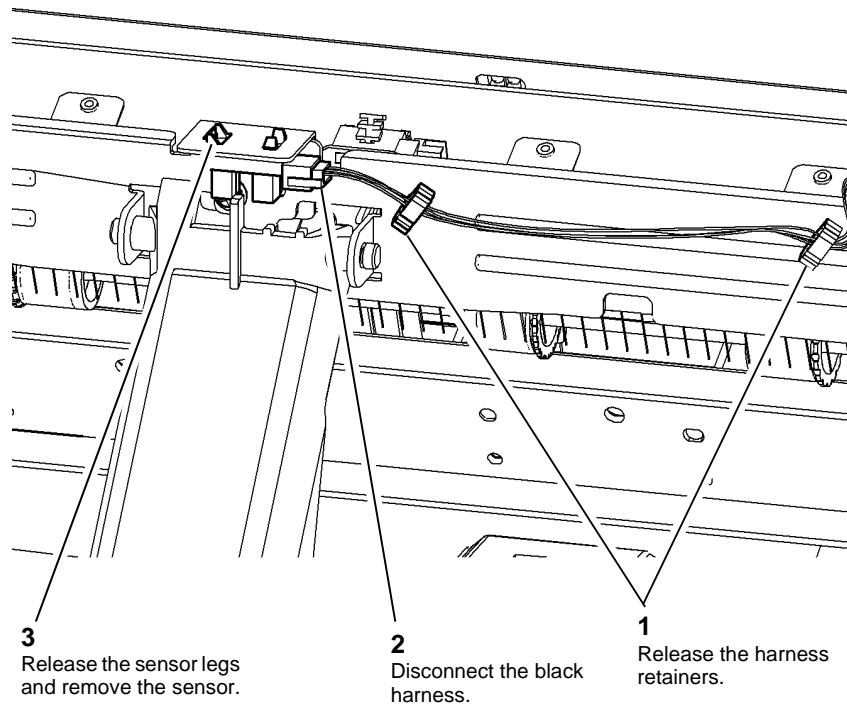
X-1-0356-A

1. Remove the lower right cover, [REP 12.45-150](#).
2. Remove the bin 2 90% full sensor, [Figure 1](#).

Figure 1 Sensor removal

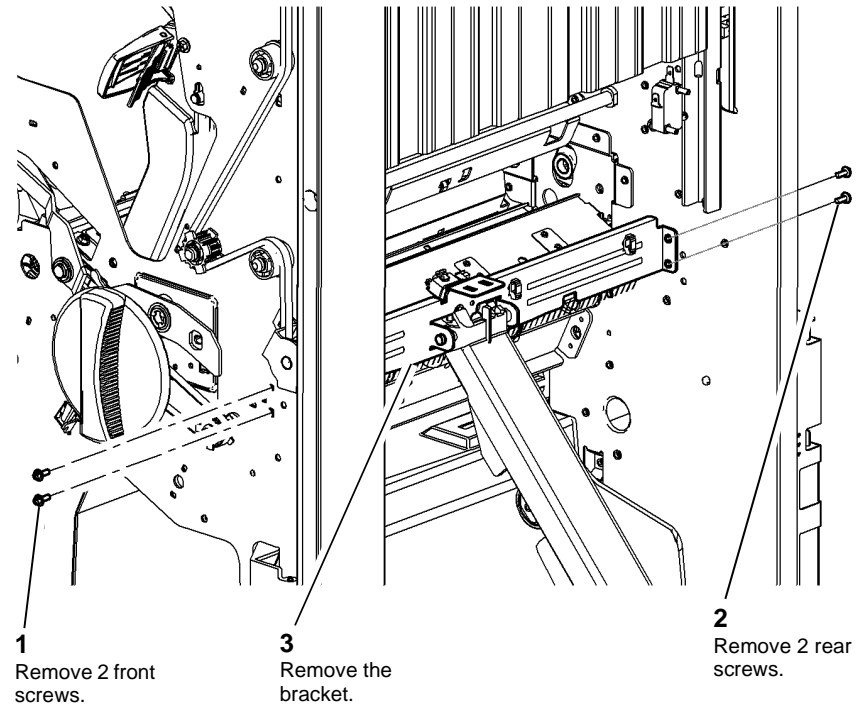
X-1-0357-A

3. Remove the bail arm support bracket and bail arm, [Figure 2](#).

Figure 2 Support bracket removal

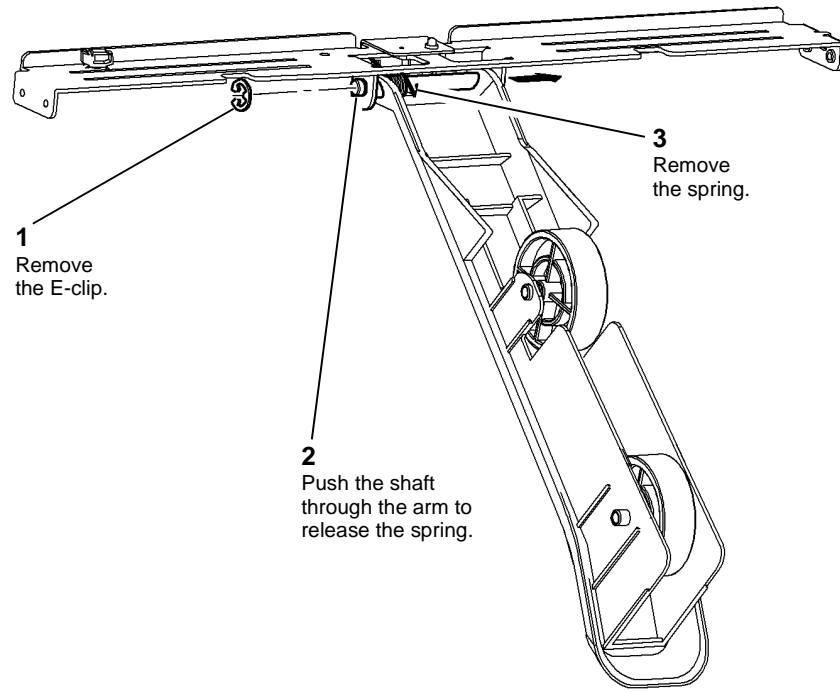
X-1-0358-A

4. Remove the bail arm spring, [Figure 3](#).

Figure 3 Bail arm spring removal

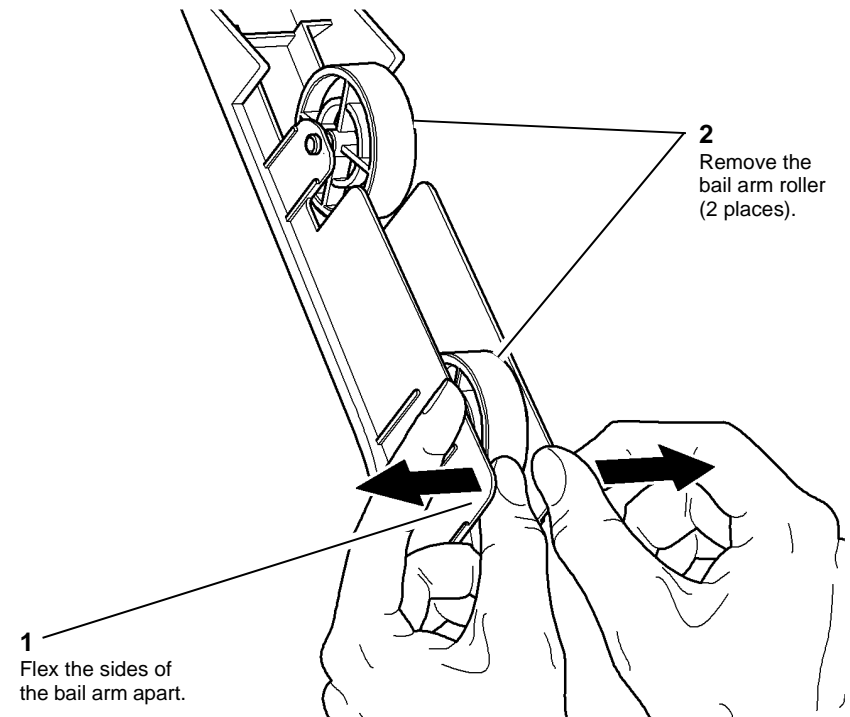
X-1-0359-A

5. Remove the bail arm roller, [Figure 4](#).

Figure 4 Bail arm roller removal

NOTE: The bail arm rollers can be removed with the bail arm installed on the LVF BM.

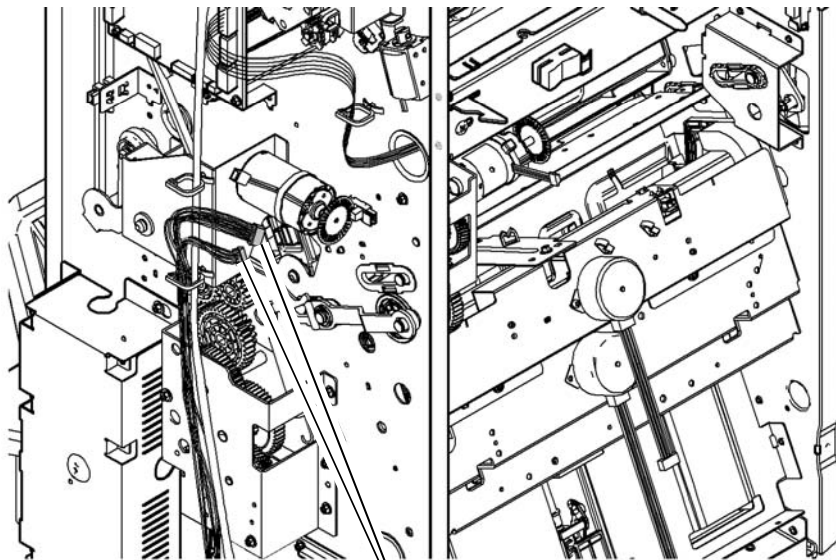
X-1-0360-A

1. Un-dock the LVF BM, [REP 12.13-150](#).
2. Remove the LVF BM front door cover assembly, rear cover and LVF BM back stop cover, [REP 12.1-150](#).
3. Disconnect the harnesses, [Figure 1](#).

1
Disconnect 2 harnesses.

Figure 1 Disconnecting harnesses

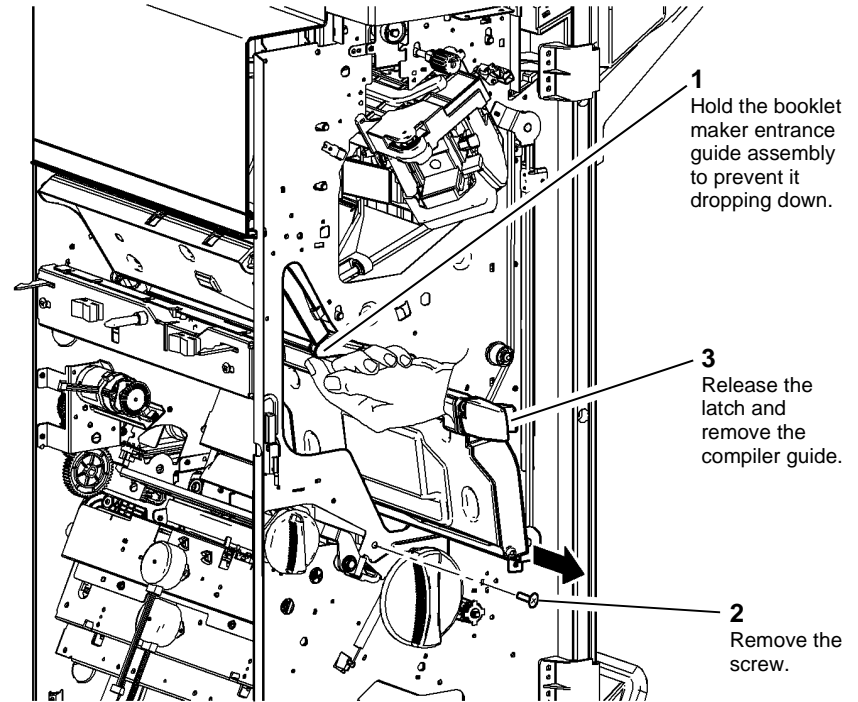
X-1-0361-A

4. Remove the BM compiler guide assembly, [Figure 2](#).

Figure 2 Compiler guide removal

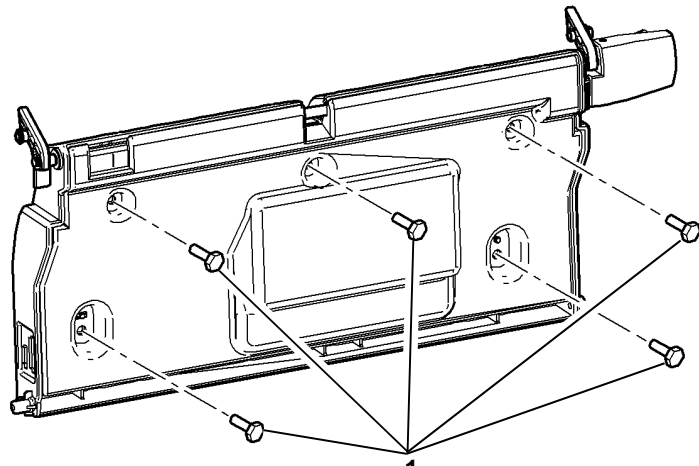
X-1-0362-A

5. Remove the BM compiler guide assembly cover, [Figure 3](#).

1 Remove 5 screws.
Figure 3 Cover removal

2 Remove the cover.

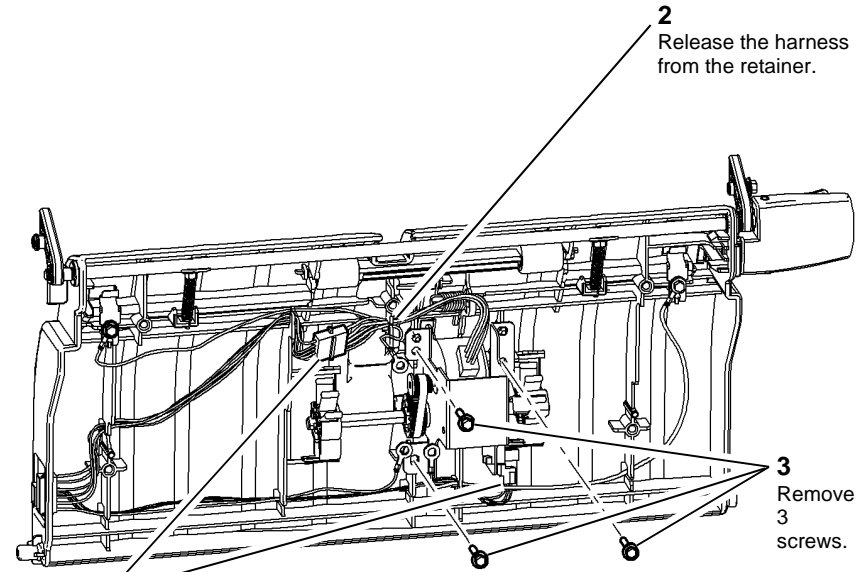
6. Remove the BM flapper motor assembly, [Figure 4](#).

1 Disconnect 2 harnesses.

4 Remove the motor assembly.

Figure 4 Motor assembly removal

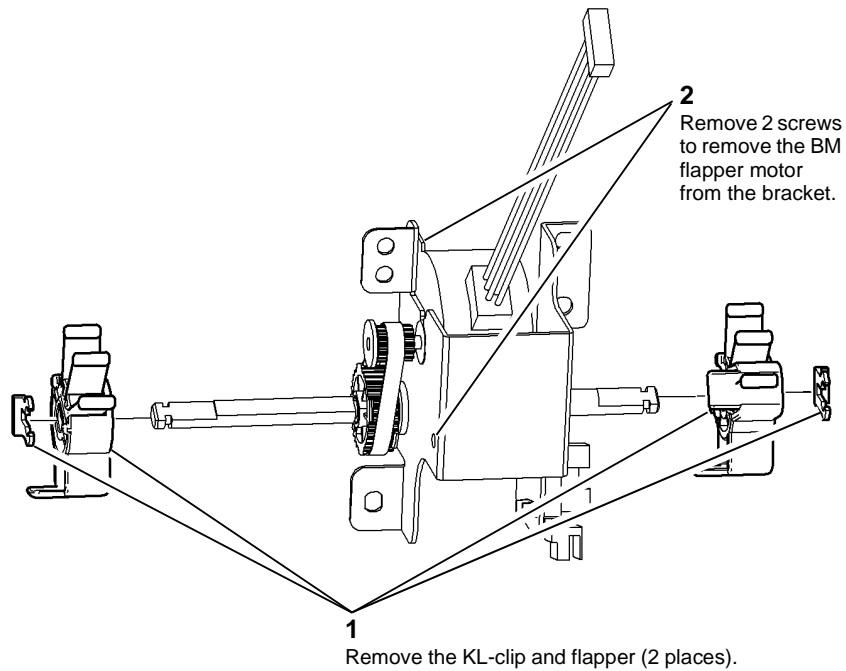
X-1-0364-A

- Remove the BM compiler flappers, [Figure 5](#).

Figure 5 BM compiler flapper removal
