708P91368
September 2017

Xerox® AltaLink® B8090 Family Multifunction Printer Service Manual

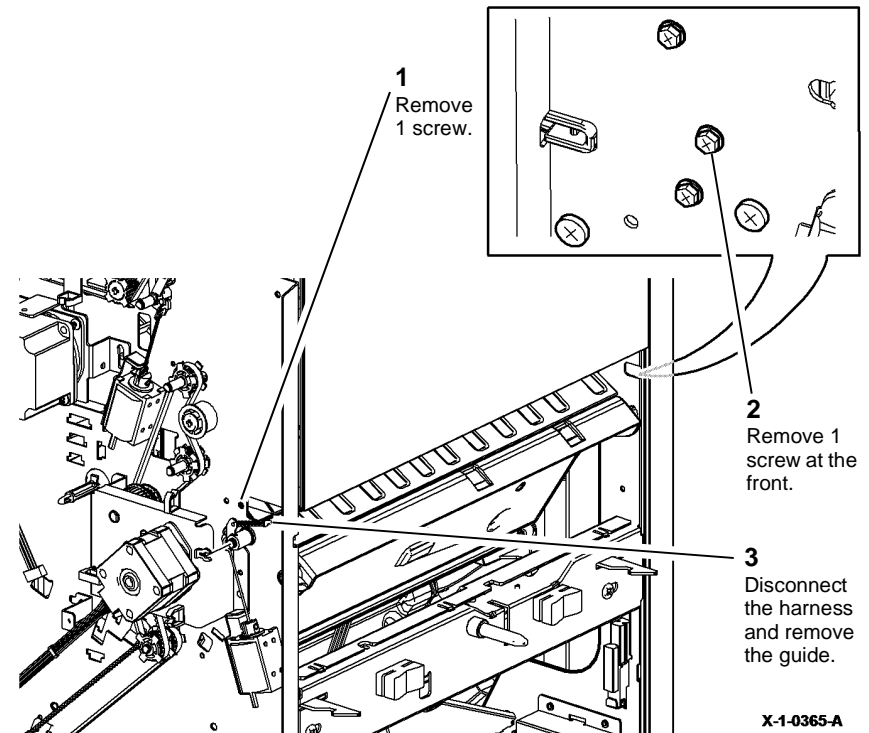
X-1-0365-A

- Un-dock the LVF BM, [REP 12.13-150](#).
- Remove the LVF BM front door cover assembly and rear cover, [REP 12.1-150](#).
- Remove the upper entrance guide, [Figure 1](#).

Figure 1 Upper entrance guide removal

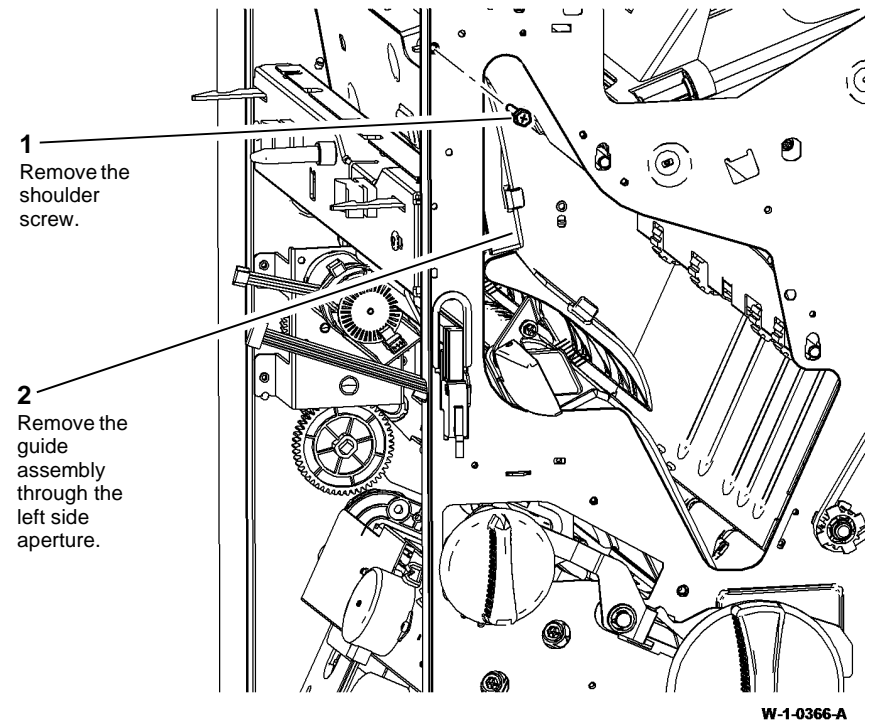
1. Un-dock the LVF BM, [REP 12.13-150](#).
2. Remove the LVF BM front door cover assembly and rear cover, [REP 12.1-150](#).
3. Remove the BM entrance guide assembly, [Figure 1](#).

Figure 1 Entrance guide removal

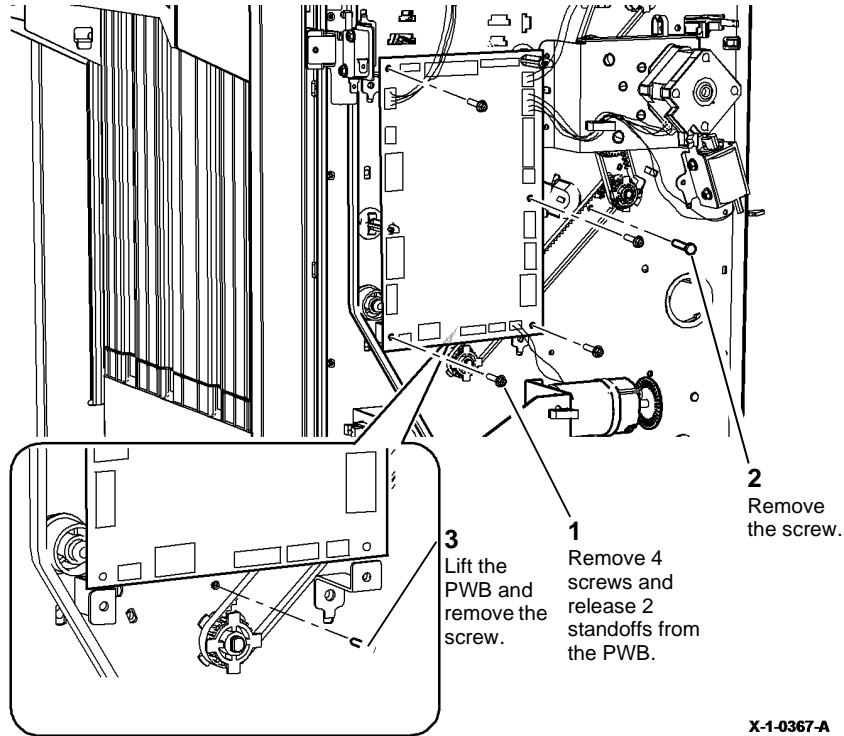
4. Remove the BM compiler guide assembly, [REP 12.30-150](#).
5. Prepare to remove the BM lower guide, [Figure 2](#).

Figure 2 Preparation

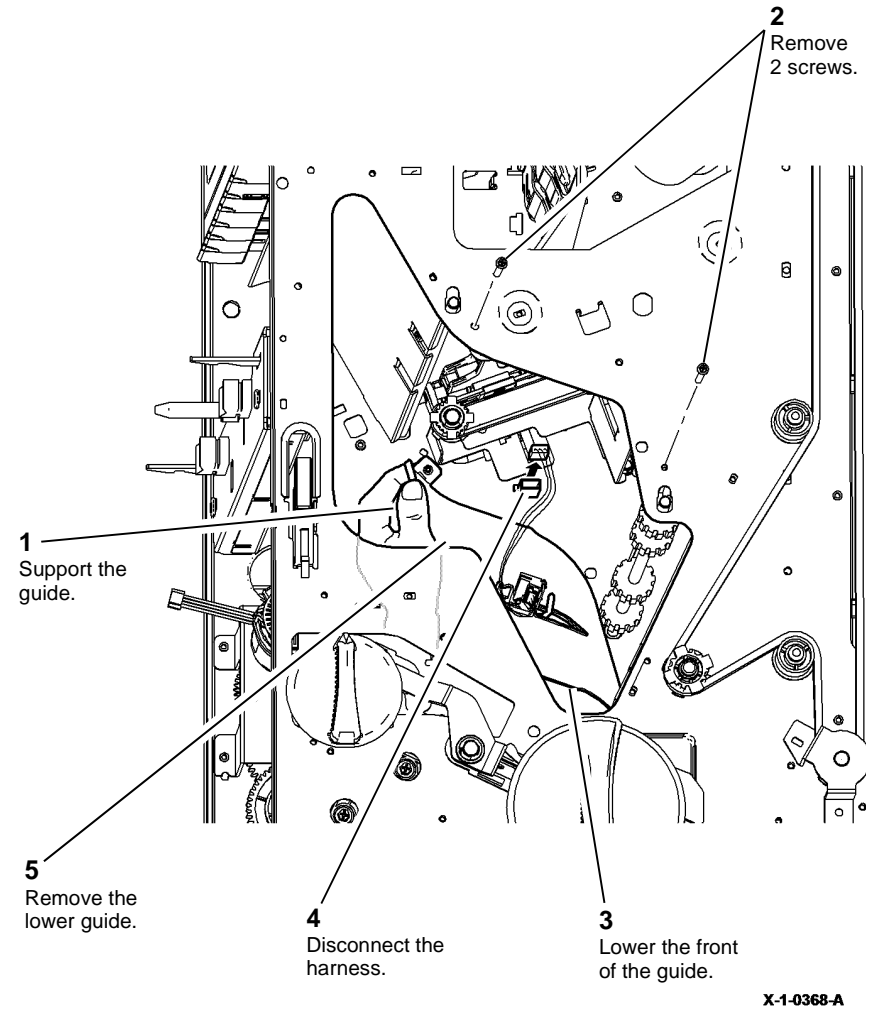
6. Remove the BM lower guide, [Figure 3](#).

Figure 3 BM lower guide removal

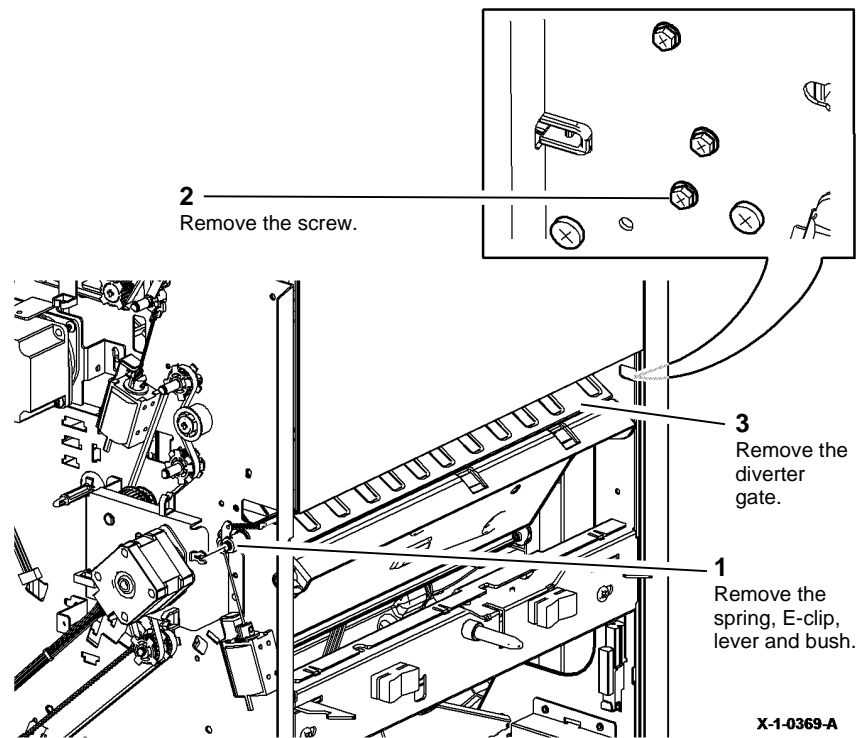
1. Un-dock the LVF BM, [REP 12.13-150](#).
2. Remove the LVF BM front door cover assembly and rear cover, [REP 12.1-150](#).
3. Remove the upper entrance guide, [REP 12.31-150](#).
4. Remove the booklet diverter gate, [Figure 1](#).

Figure 1 Diverter gate removal

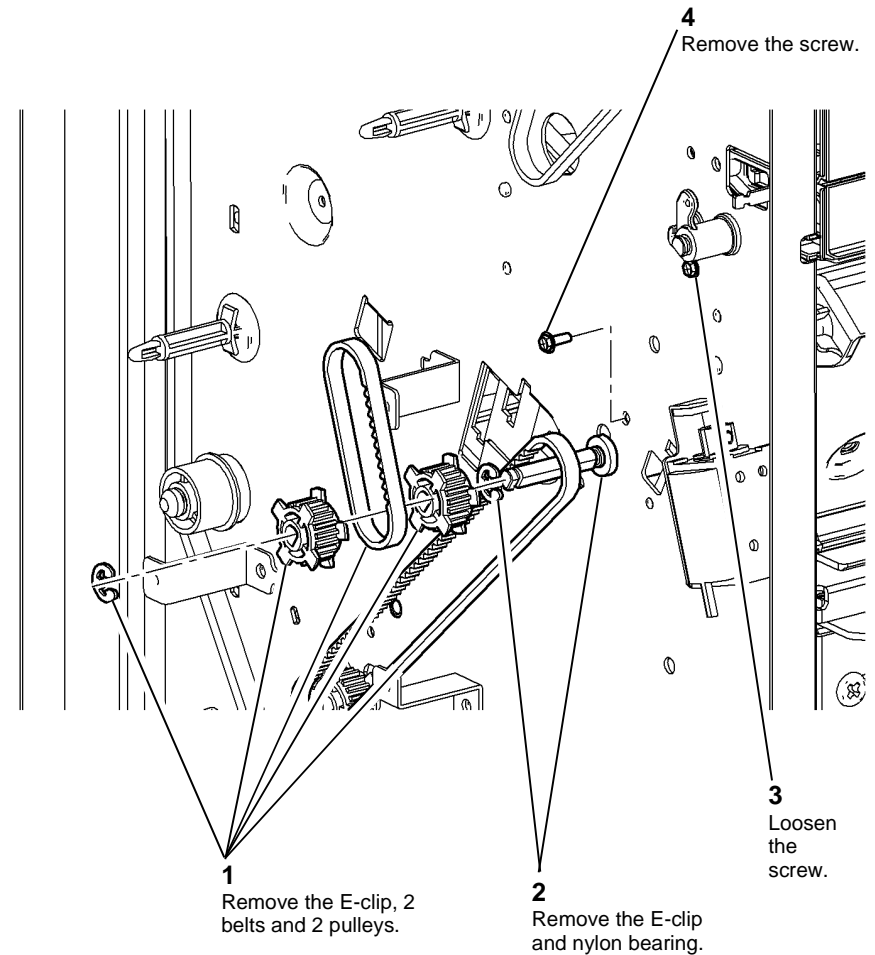
4. Remove the rear components, [Figure 1](#).

Figure 1 Rear components removal

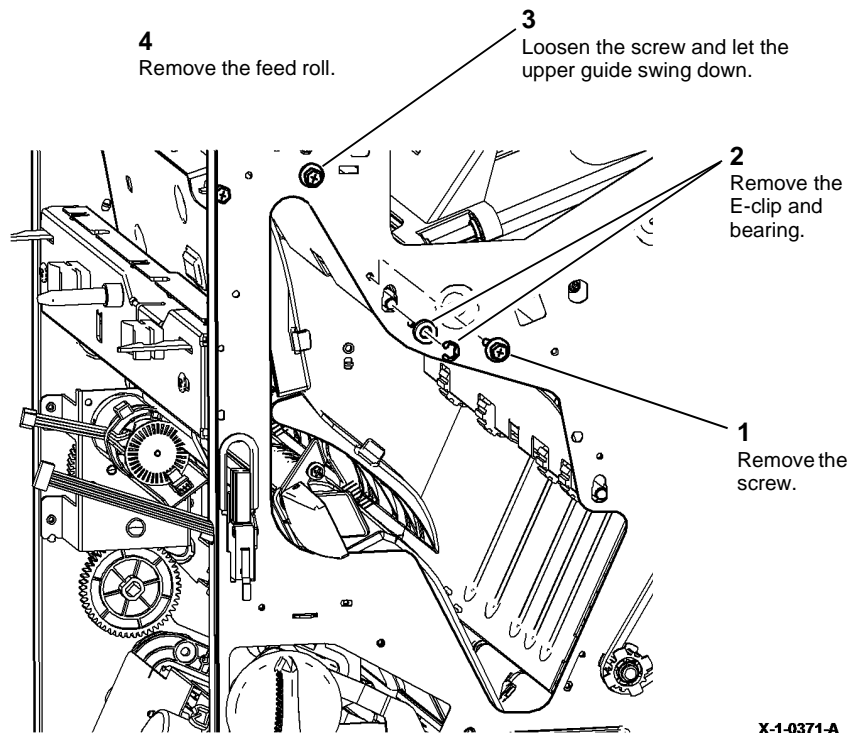
6. Remove the BM 1st feed roll assembly, [Figure 2](#).

Figure 2 1st feed roll removal

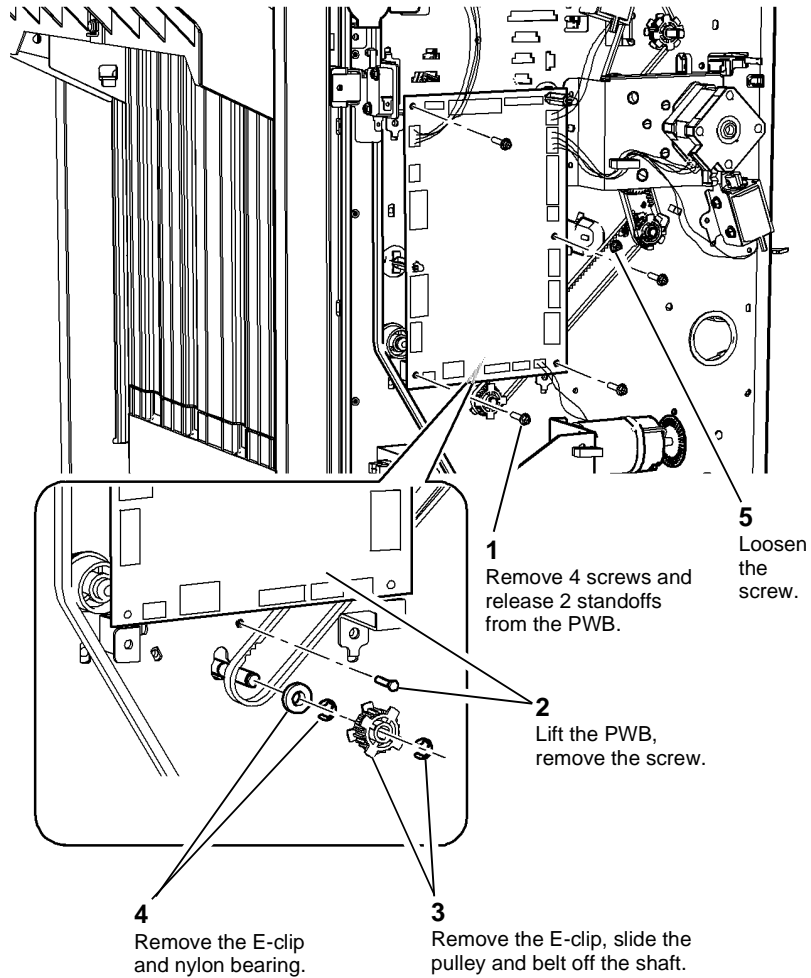
- Remove the rear components, [Figure 1](#).

Figure 1 Rear components removal

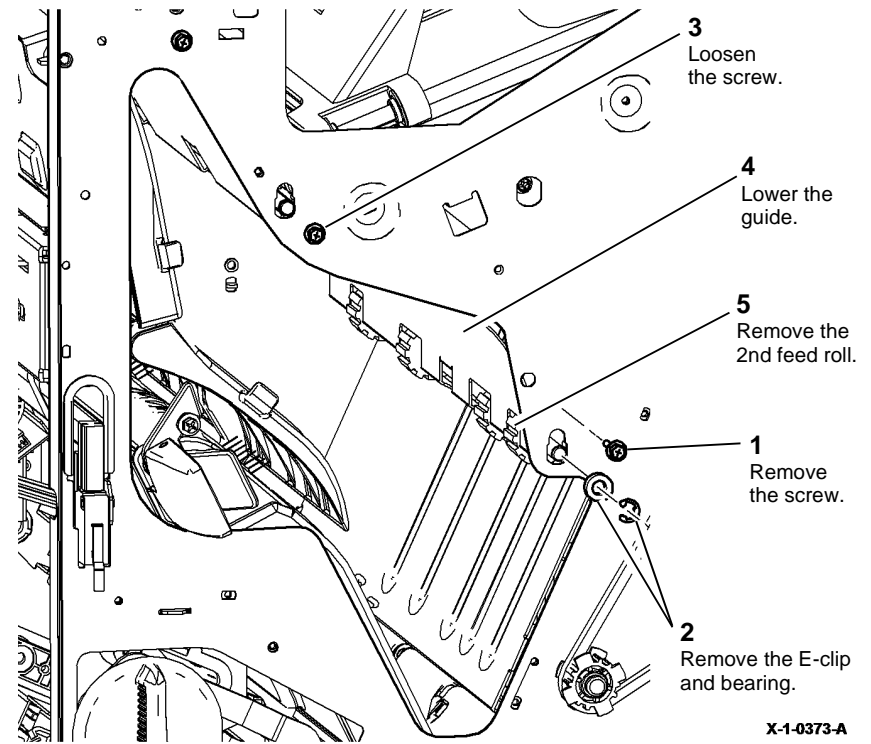
- Remove the BM 2nd feed roll assembly, [Figure 2](#).

NOTE: Take care when lowering the guide in [Figure 2](#), so that the harness to the BM entry sensor does not become disconnected.

Figure 2 2nd feed roll removal

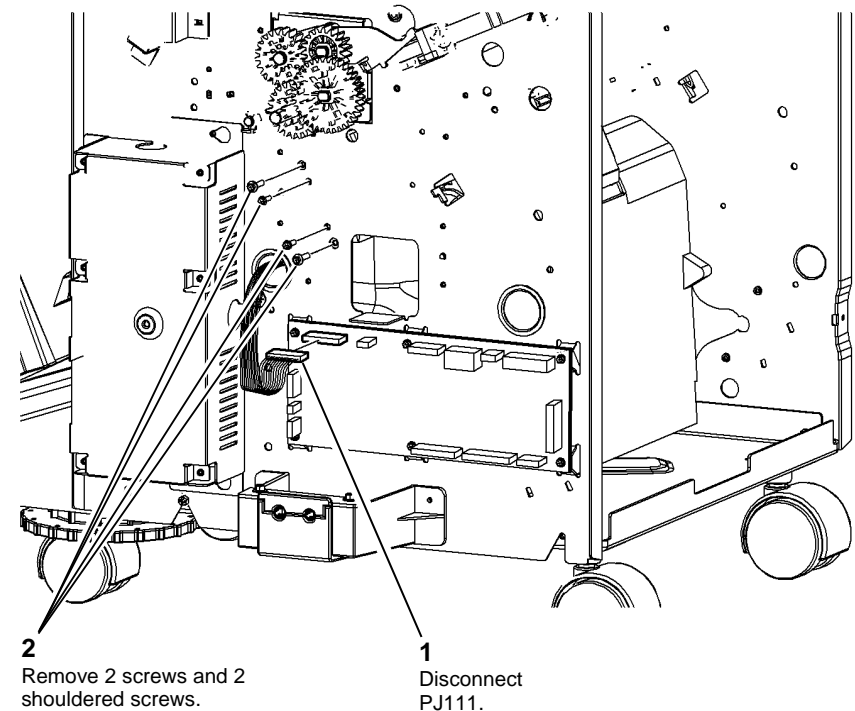
1. Remove the right guide assembly. Refer to [REP 12.19-150](#).
2. Prepare to remove the BM staple cartridge assembly, [Figure 1](#).

Figure 1 Preparation

1. Insert and tighten the 4 shouldered screws, [Figure 1](#) and [Figure 2](#).
2. The remainder of the replacement is the reverse of the removal procedure.

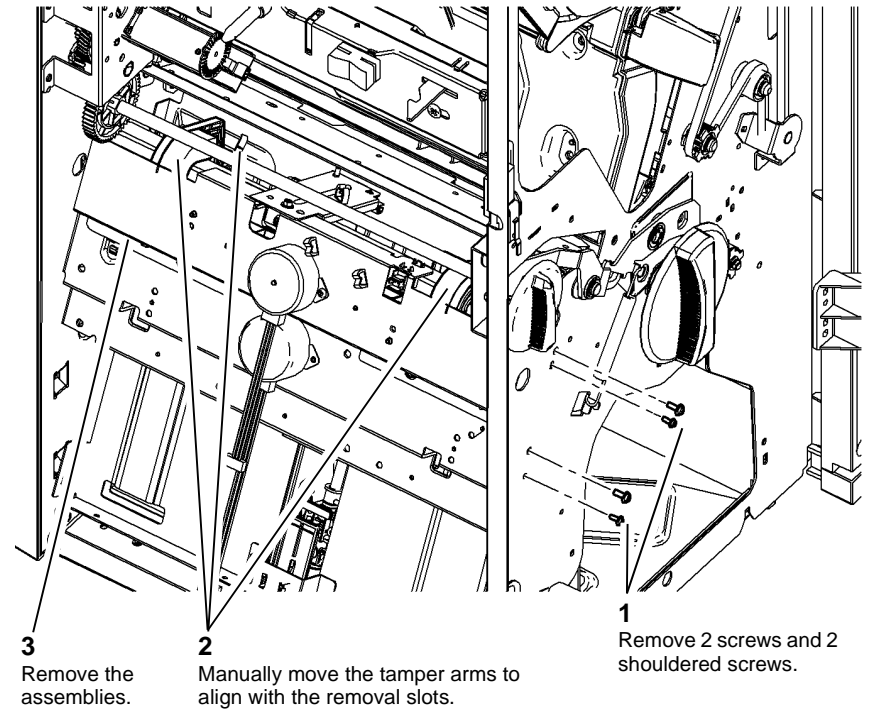
4. Remove the BM stapler assembly and booklet tamper assembly, [Figure 2](#).

Figure 2 Assemblies removal

- The replacement is the reverse of the removal procedure.
- When installing the BM stapler assembly and booklet tamper assembly, first insert and tighten the 4 shouldered screws, [Figure 1](#) and [Figure 2](#), then continue with the remainder of the installation.
- Perform [ADJ 12.5-150](#) Booklet Staple Position.

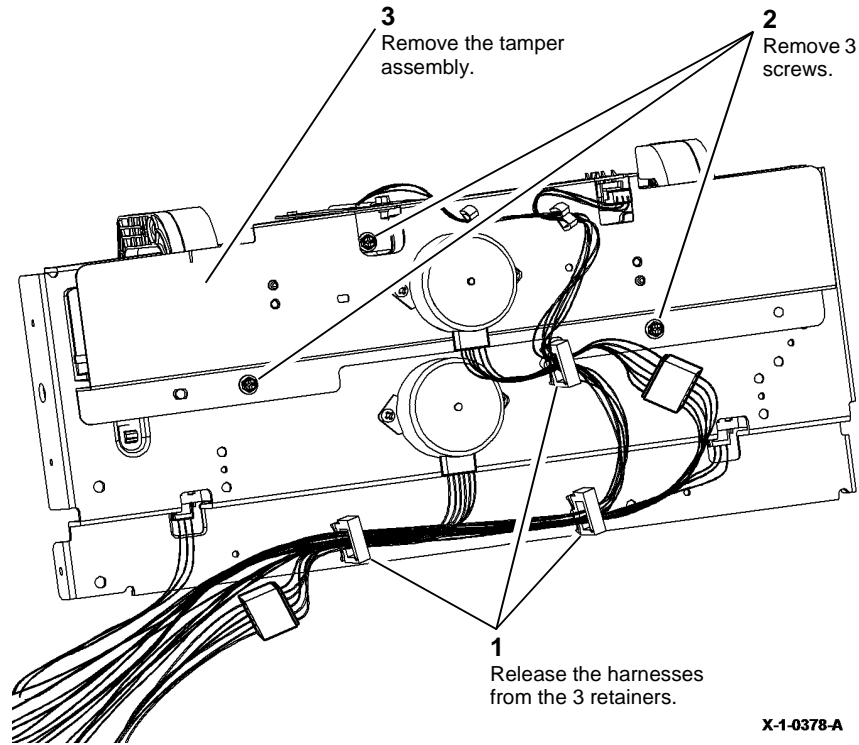
- Separate the BM stapler assembly from the booklet tamper assembly, [Figure 3](#).

Figure 3 Stapler assembly removal

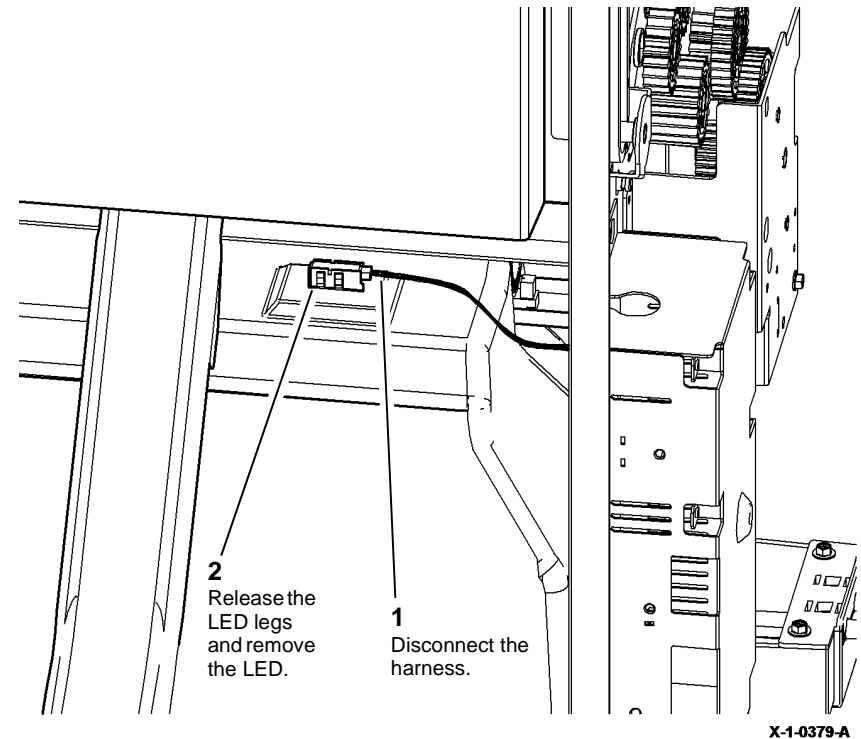
- Remove the bin 2 support, [REP 12.44-150](#).
- Remove the BM staple cartridge LED, [Figure 1](#).

Figure 1 Staple cartridge LED removal

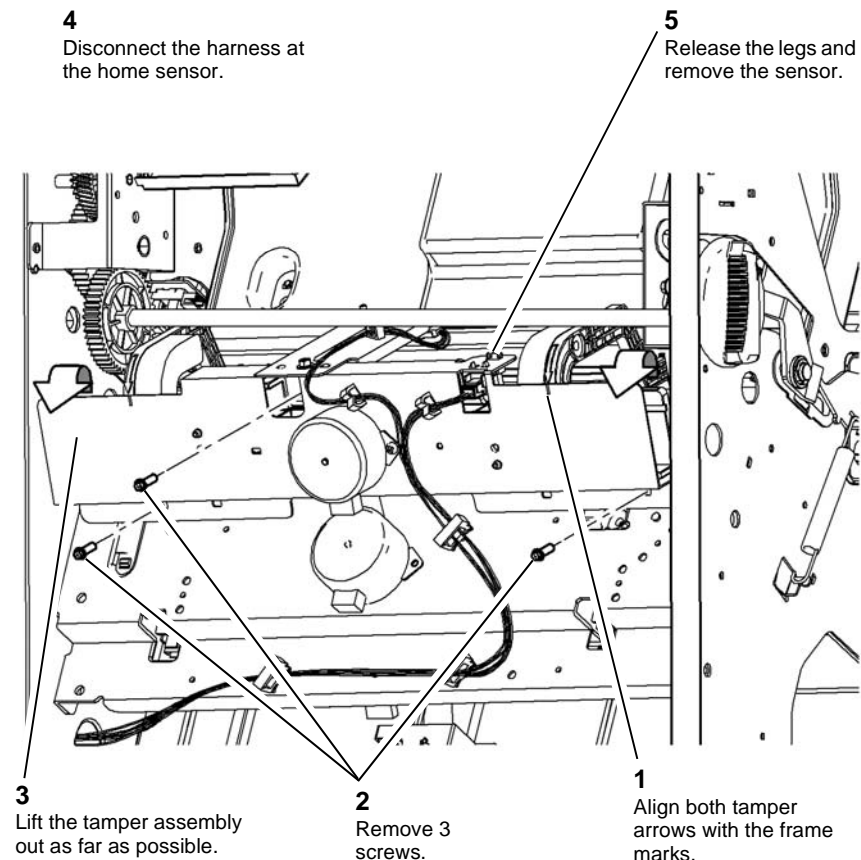
1. Un-dock the LVF BM, [REP 12.13-150](#).
2. Remove the LVF BM LVF BM back stop cover, [REP 12.1-150](#).
3. Remove the BM tamper 1 home sensor, [Figure 1](#).

Figure 1 Home sensor removal

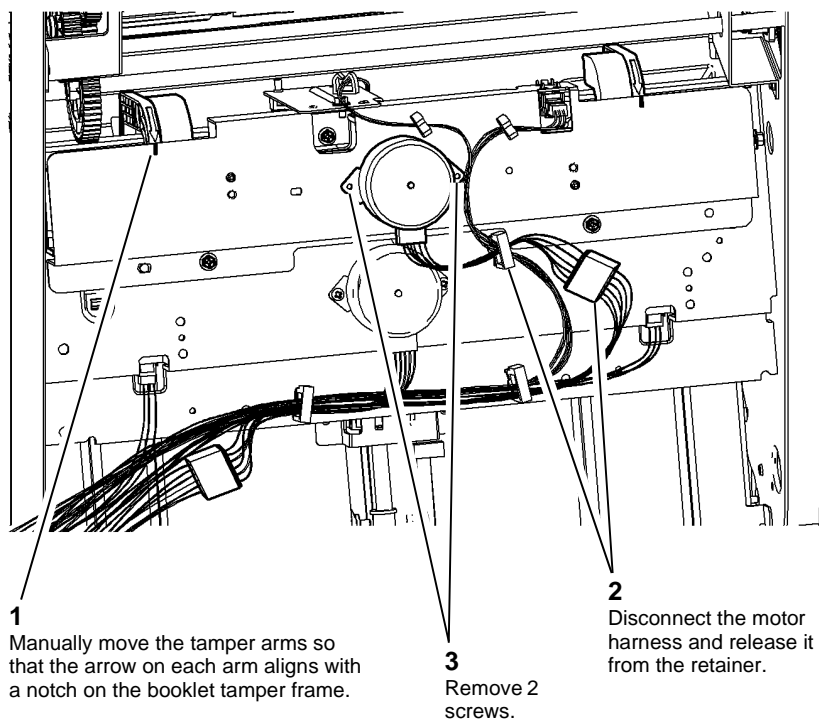
1 Manually move the tamper arms so that the arrow on each arm aligns with a notch on the booklet tamper frame.

3 Remove 2 screws.

Figure 1 Preparation

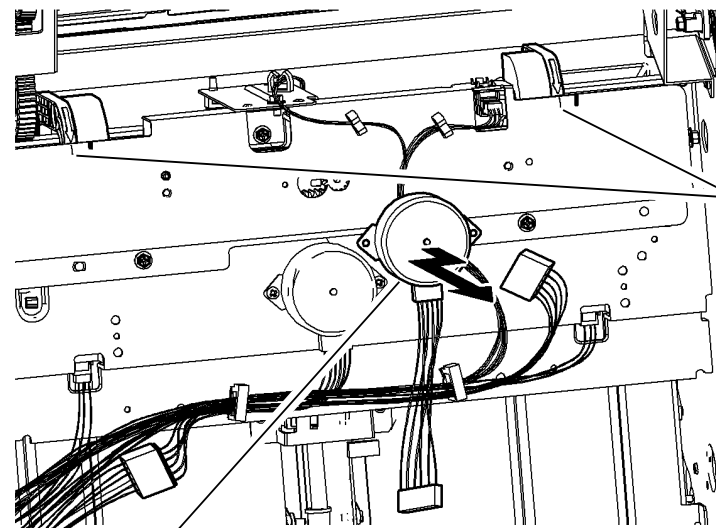
4. Remove the booklet tamper motor, [Figure 2](#).

1 Pull the motor out by approximately 1mm (0.04 inch), slide the motor approximately 12mm (0.5 inch) to the rear, pull the motor out to remove.

2 Without moving the tamper arms, place a pencil mark on the booklet tamper frame in line with each tamper arm arrow.

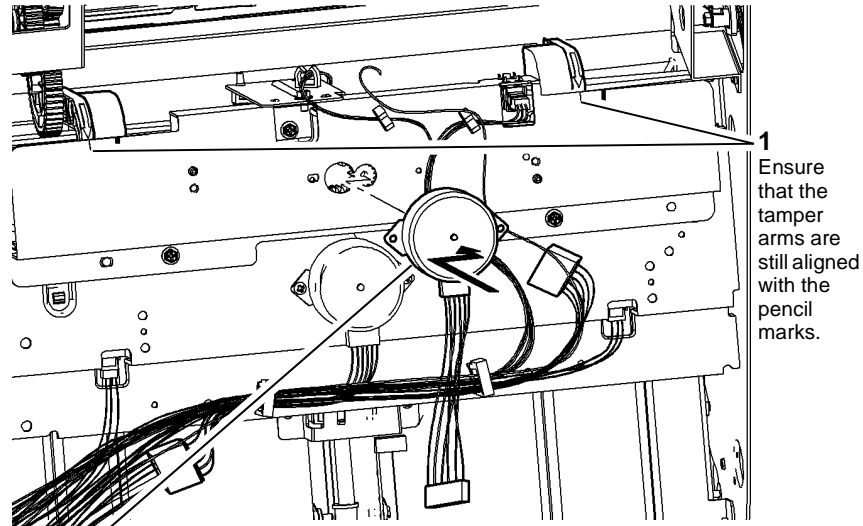
1. Prepare to install the booklet tamper motor, [Figure 3](#).

Figure 3 Preparation

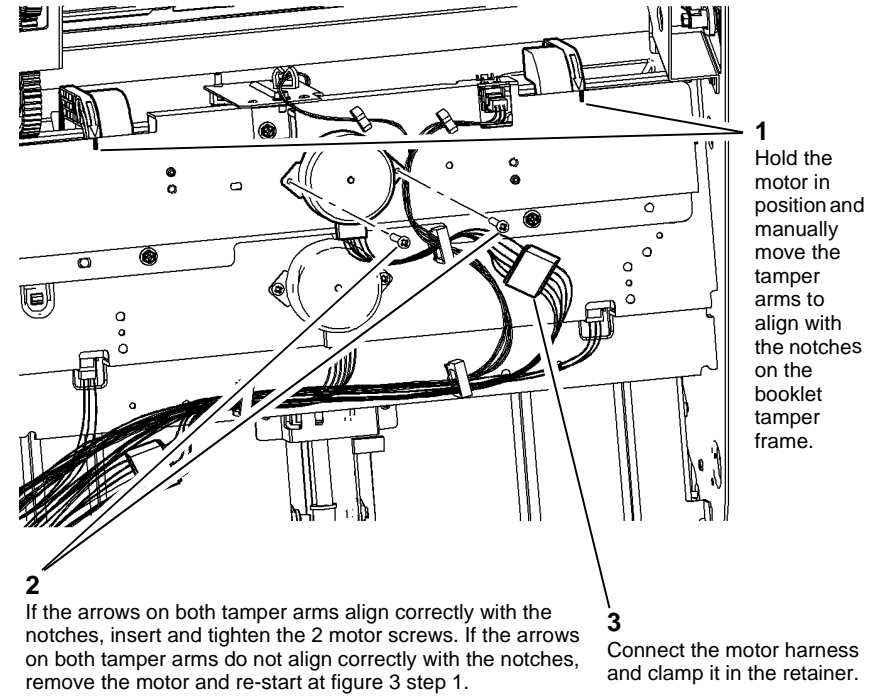
2. Install the booklet tamper motor, [Figure 4](#).

Figure 4 Tamper motor installation

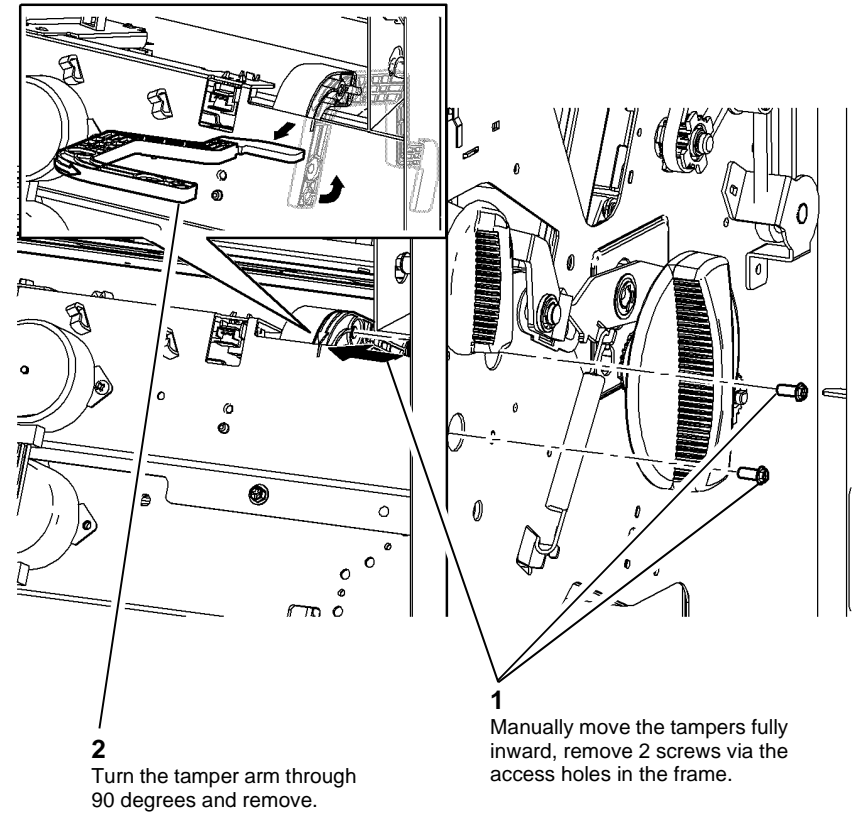
1. Un-dock the LVF BM, [REP 12.13-150](#).
2. Remove the LVF BM front door cover assembly and rear cover, [REP 12.1-150](#).
3. Remove the front booklet tamper arm, [Figure 1](#).

Figure 1 Front tamper arm removal

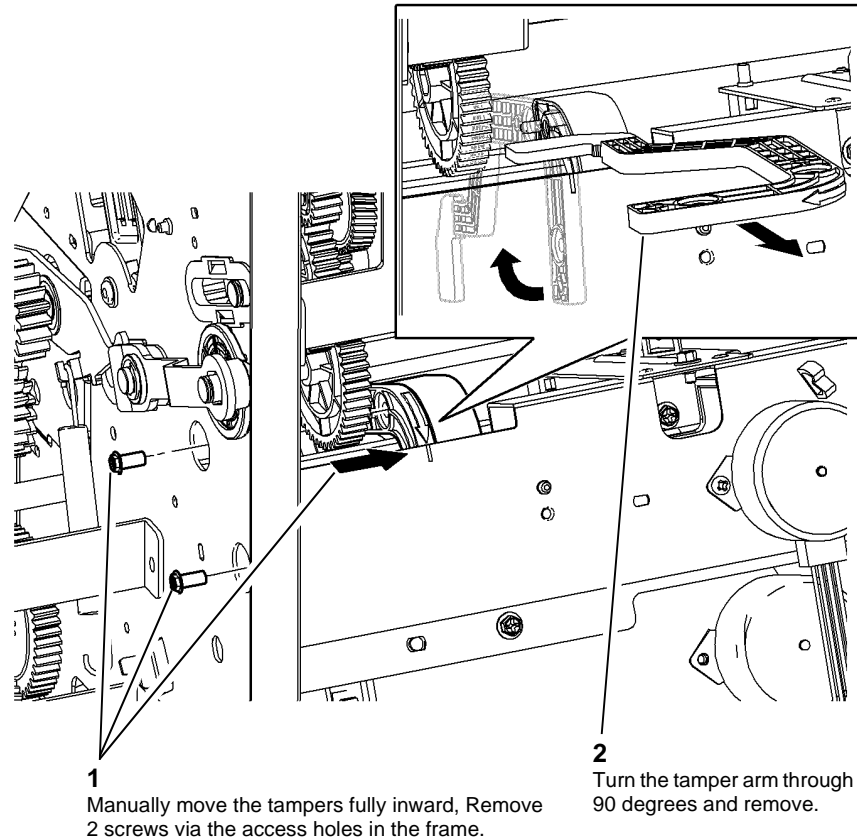
- Remove the rear booklet tamper arm, [Figure 2](#).

- Manually move the tampers fully inward, Remove 2 screws via the access holes in the frame.
- Turn the tamper arm through 90 degrees and remove.

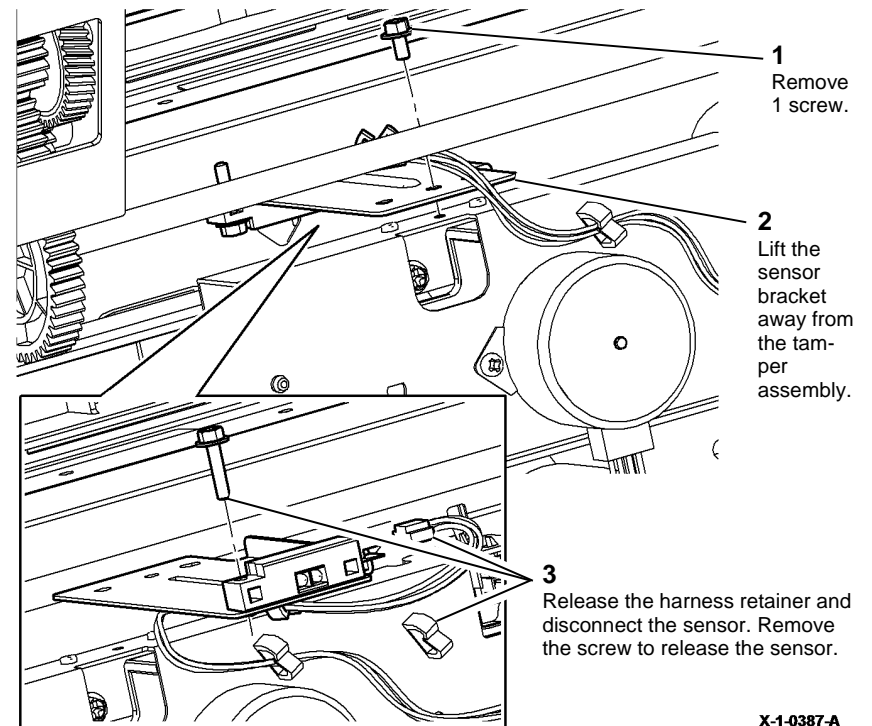
- Un-dock the LVF BM, [REP 12.13-150](#).
- Remove the sensor bracket, [Figure 1](#).

- Remove 1 screw.
- Lift the sensor bracket away from the tamper assembly.
- Release the harness retainer and disconnect the sensor. Remove the screw to release the sensor.

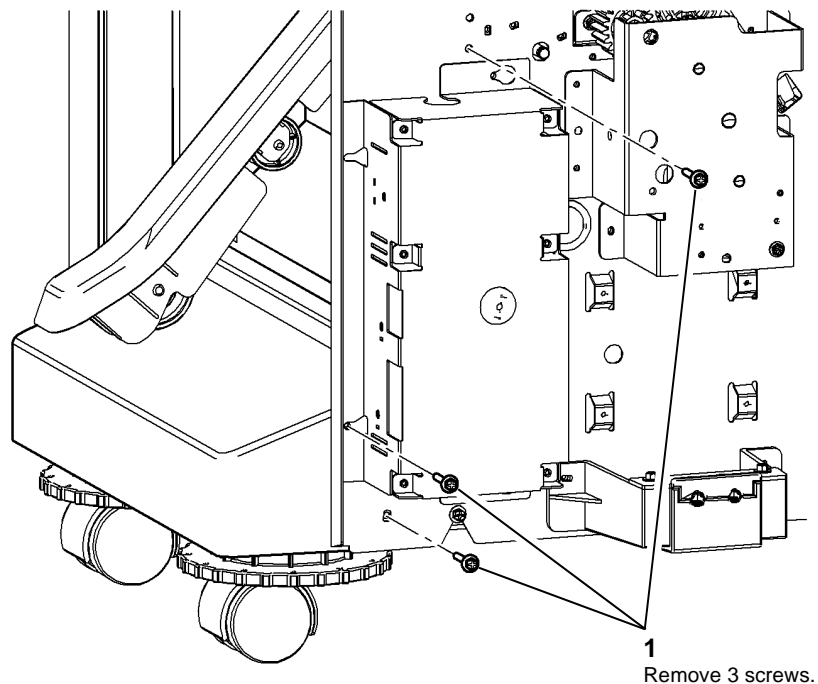
1
Remove 3 screws.

Figure 1 Preparation

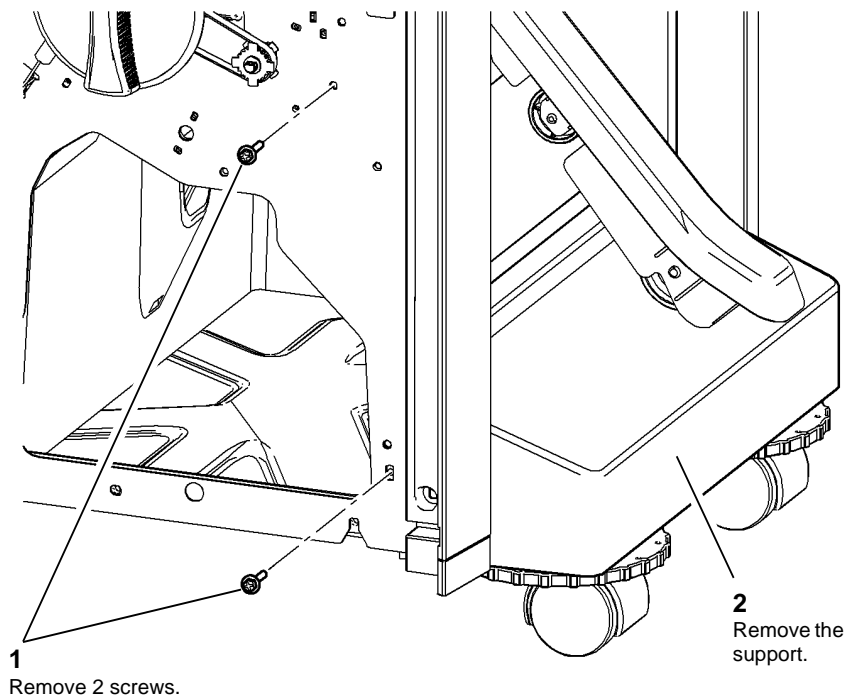
5. Remove the bin 2 support, [Figure 2](#).

1
Remove 2 screws.

2
Remove the support.

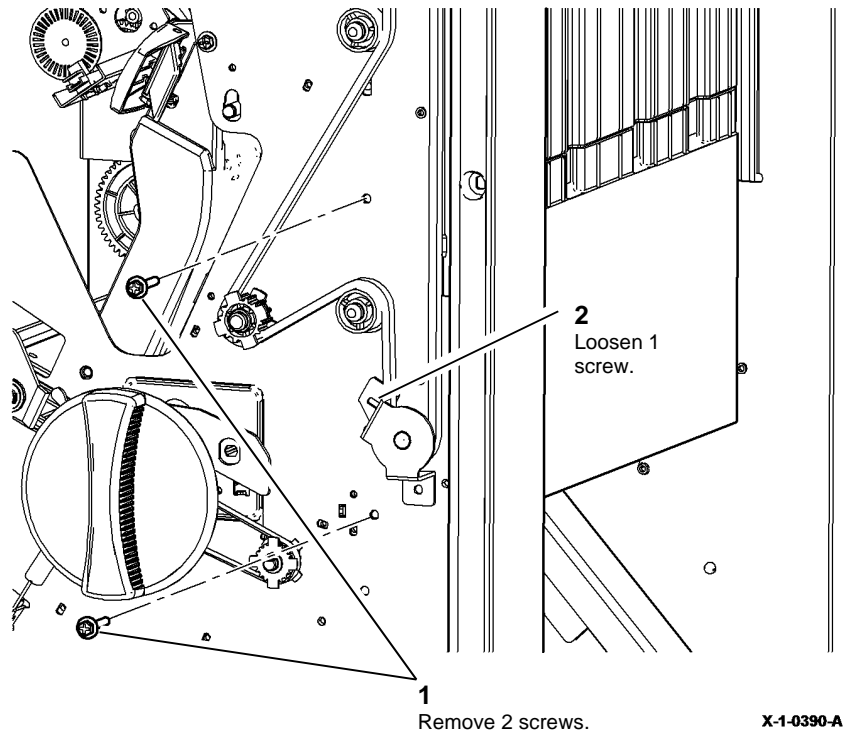
1. Remove the bin 2 support, [REP 12.44-150](#).
2. Prepare to remove the lower right cover, [Figure 1](#).

Figure 1 Preparation

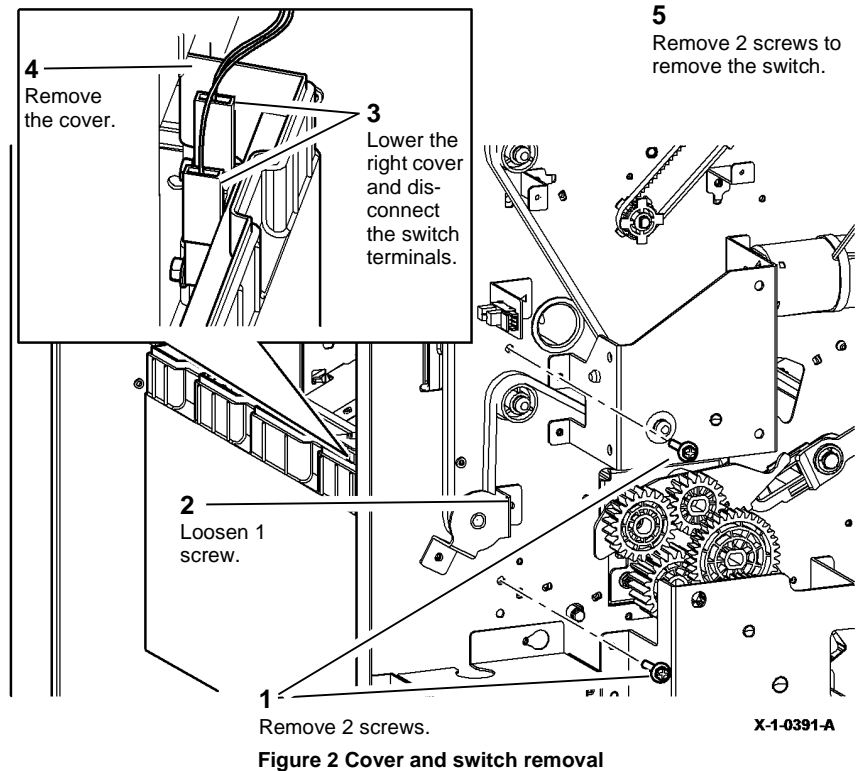
3. Remove the lower right cover and bin 1 lower limit switch, [Figure 2](#).

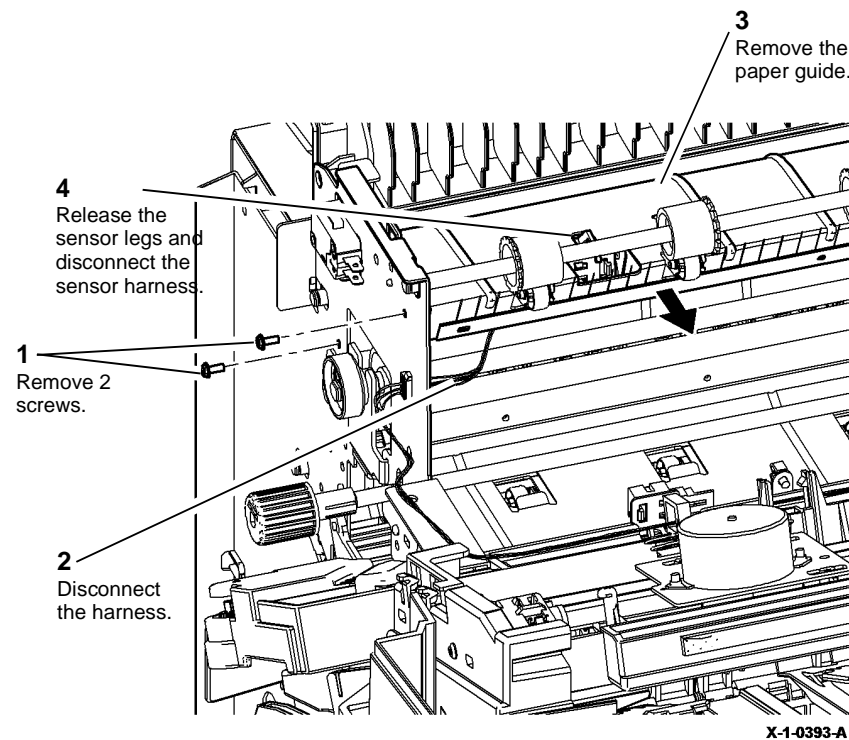
5. Remove the paper guide and top tray exit sensor, Q12-107, [Figure 2](#).

Figure 2 Guide and sensor removal

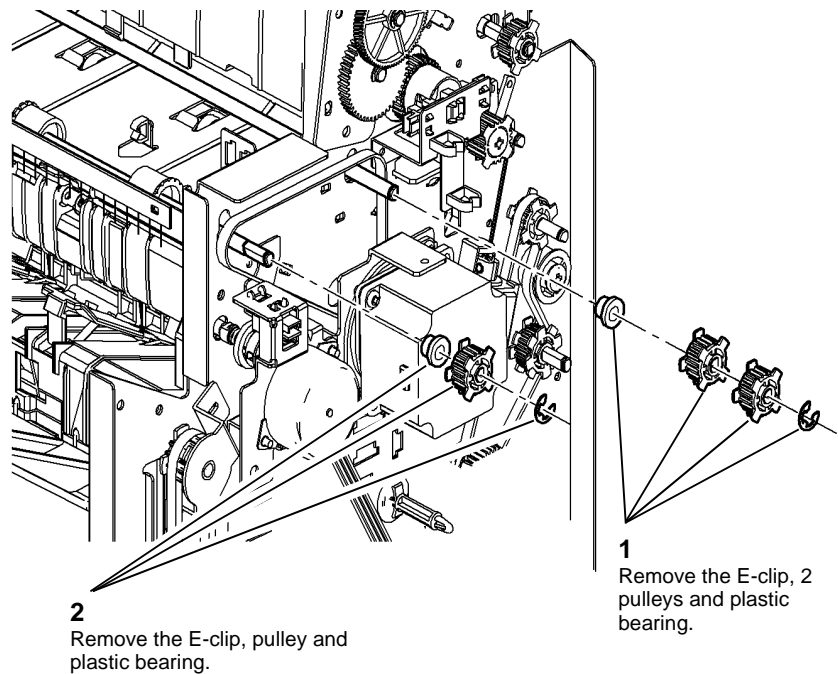
1. Un-dock the LVF BM, [REP 12.13-150](#).
2. Remove the LVFBM top cover, rear cover and front door cover assembly, [REP 12.1-150](#).
3. Remove the tamper assembly, [REP 12.6-150](#).
4. Remove the paper output drive belt, [REP 12.4-150](#).
5. Prepare to remove the drive shafts [Figure 1](#).

Figure 1 Preparation

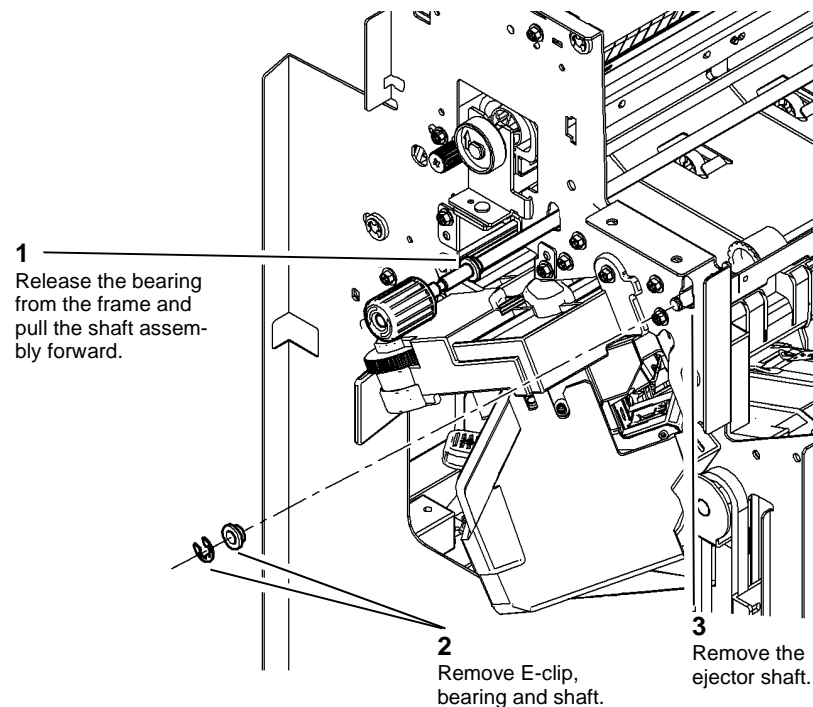
6. Remove the ejector drive shaft, [Figure 2](#).

Figure 2 Ejector shaft removal

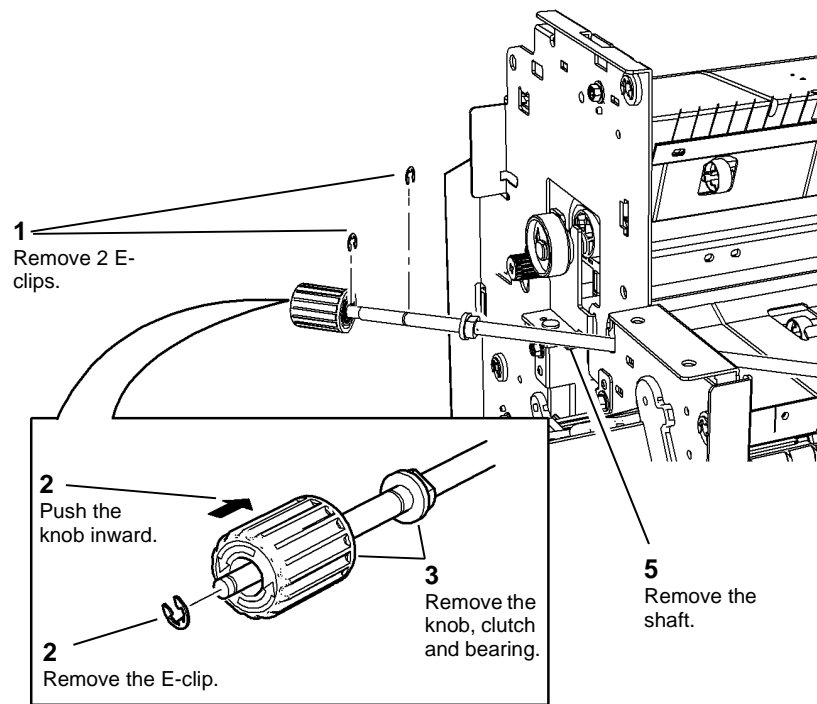
7. Remove the drive shaft, [Figure 3](#).

Figure 3 Drive shaft removal

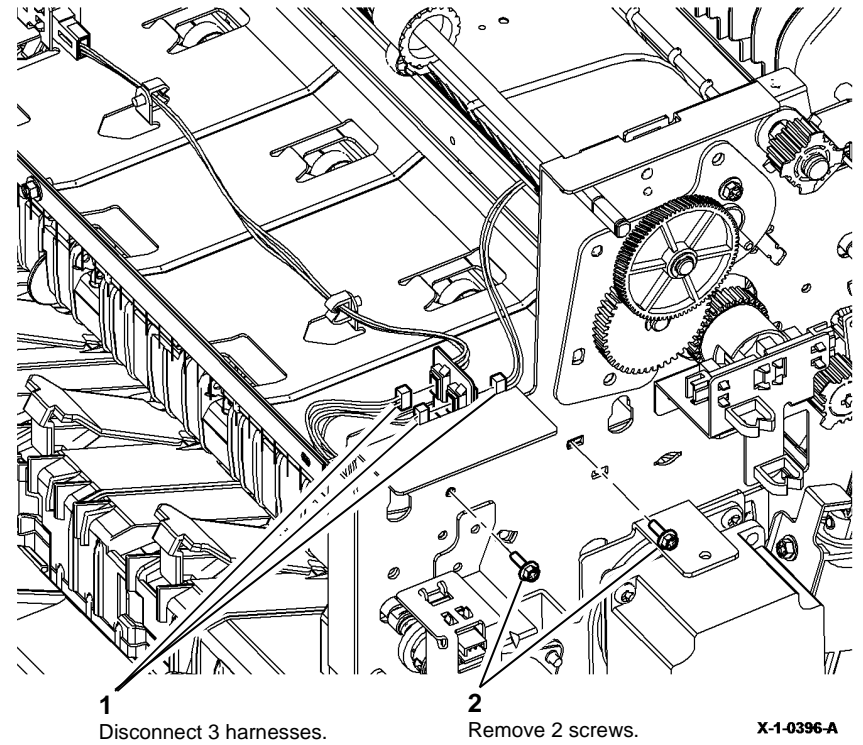
8. Prepare to remove the upper right paper guide, [Figure 4](#).

Figure 4 Preparation

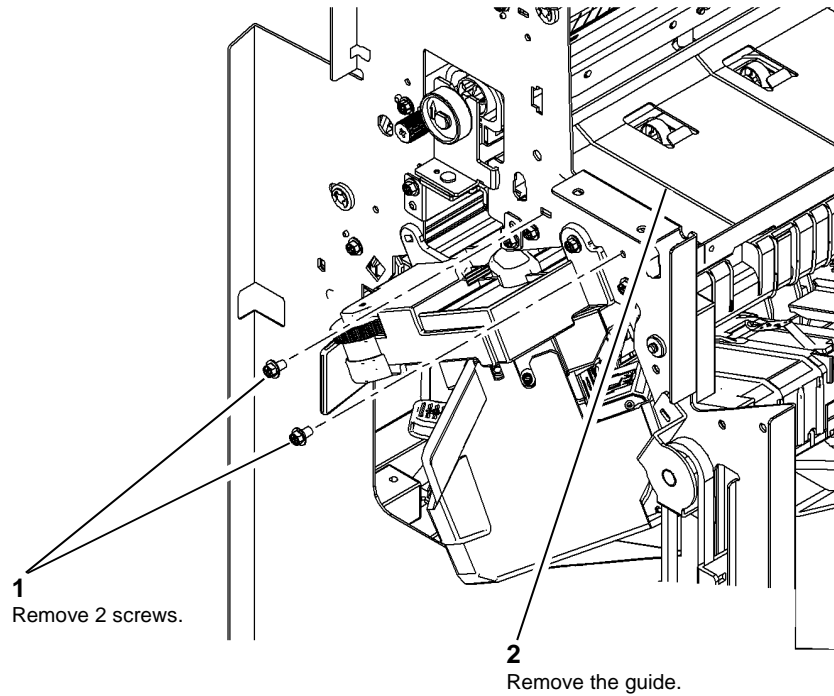
9. Remove the upper right paper guide, [Figure 5](#).

Figure 5 Upper right guide removal

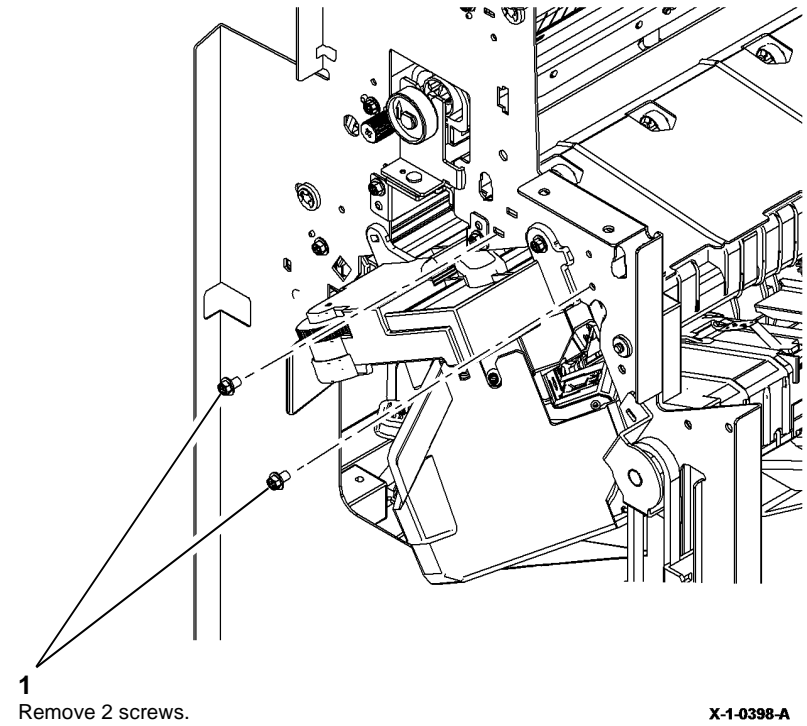
10. Prepare to remove the lower right paper guide, [Figure 6](#).

Figure 6 Preparation

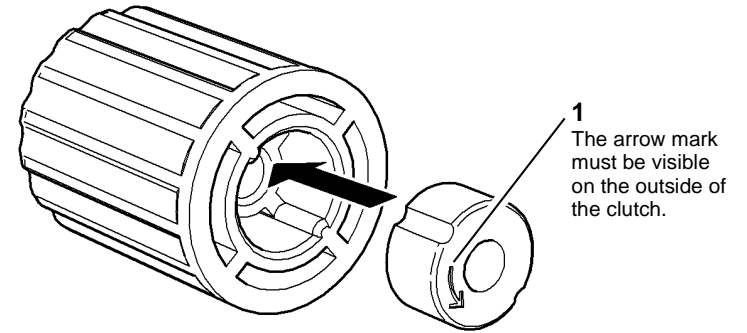
1. The replacement is the reverse of the removal procedure.
2. When replacing the jam clearance knob, ensure the one-way clutch is installed in the correct orientation, [Figure 8](#).

Figure 8 Clutch orientation

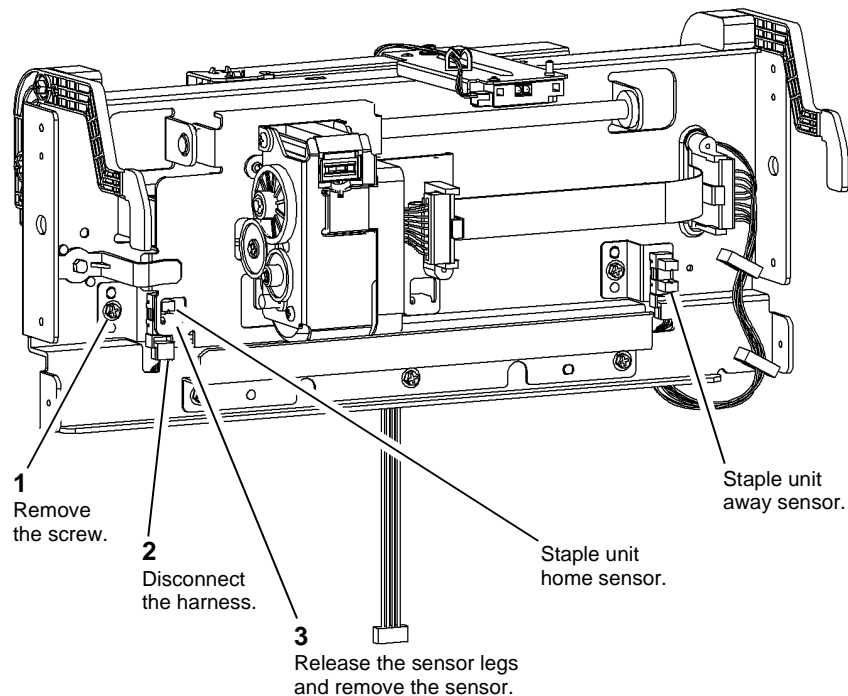
1. Remove the BM stapler assembly and booklet tamper assembly, [REP 12.38-150](#).
2. If required, remove the BM staple unit home sensor, Q12-438 or staple unit away sensor, Q12-439, [Figure 1](#).

Figure 1 Sensor removal
